**Flood Control Project Maintenance
Levee Inspections**

Maintenance Issue Types Only, Levee Inspection Report By Mile - Fall 2019

San Joaquin County Flood Control and Water Conservation District

Waterway	Bank	Unit Miles	Inspection Start/End	Inspector
Unit No. 01 Littlejohn Creek	Left	2.59	11/14/2019 11/14/2019	Alberto De Leon

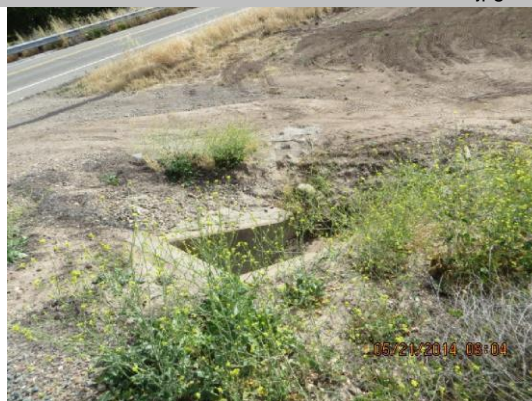
Photo 2 of 3 : UCIP_FA_2019_38130_69374.jpg

LM Start	14.31	Rating **	M	Issue No.	1190 (cont)	
LM End	14.31	Issue Type +	Ma	Location *		
Category	Supplemental			GPS Latitude/Longitude		
				Start	End	
Item	DRAFT DWR UCIP LMA Responsibility			38.116164 °	38.116164 °	
				-121.171657 °	-121.171657 °	
DWR ID	23778					
Comment Code						
Inspector Comment						
DS_ID:23778 FS_ID:38130 EP_NO: N/A Repair Type: Non-Urgent Crossing Status: Found UCIP Comments: Some silt buildup inside pipe. FIELD_STRUCT_DESC: 24-inch corrugated metal drainage pipe through the levee, 4 feet below the crown. Concrete U-shaped headwall on both ends. Flap gate on the waterside (WS) end. Cobble grouted spillway. Cobble grouted intake on the landside (LS). [Additional Reference(s): DWR Levee Log, 1990. USACE San Joaquin O&M Manual 612.2, 1967, (HLM 14.69)]. FS Date: 5/21/2014

Headwall on LS toe.

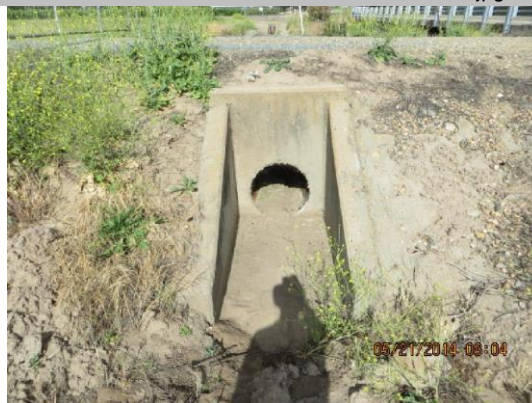
Photo 3 of 3 : UCIP_FA_2019_38130_69373.jpg

Headwall on LS toe.

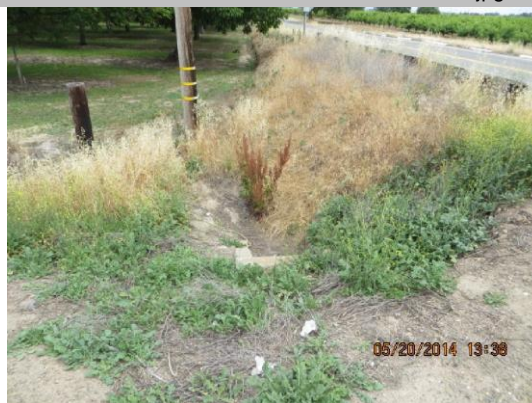
Photo 1 of 3 : UCIP_FA_2019_38129_69370.jpg

LM Start	14.32	Rating **	A/W	Issue No.	1192	
LM End	14.32	Issue Type +	Ma	Location *		
Category	Supplemental			GPS Latitude/Longitude		
				Start	End	
Item	DRAFT DWR UCIP LMA Responsibility			38.116420 °	38.116420 °	
				-121.171643 °	-121.171643 °	
DWR ID	23779					
Comment Code						
Inspector Comment						
DS_ID:23779						
FS_ID:38129						
EP_NO: N/A						
Repair Type: No Action Needed						
Crossing Status: Found						
UCIP Comments:						
FIELD_STRUCT_DESC: 24-inch corrugated metal drainage pipe through the levee, 6.5 feet below the crown. Concrete U-shaped headwall on both ends. Flap gate on the waterside (WS) end. Cobble grouted spillway. Cobble grouted intake on the landside (LS). [Additional Reference(s): DWR Levee Log, 1990. USACE San Joaquin O&M Manual 612.2, 1967, (HLM 14.70)].						
FS Date: 5/20/2014

Headwall on LS toe.

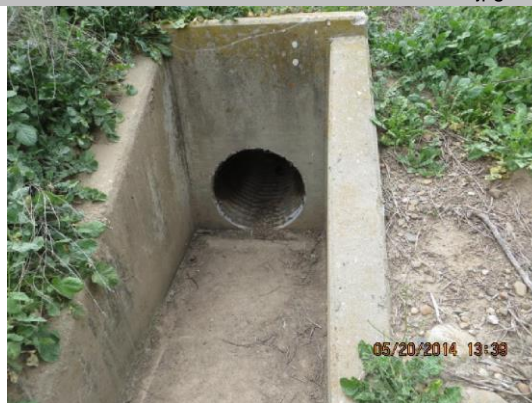
Photo 3 of 3 : UCIP_FA_2019_38129_69368.jpg

Headwall at LS toe.

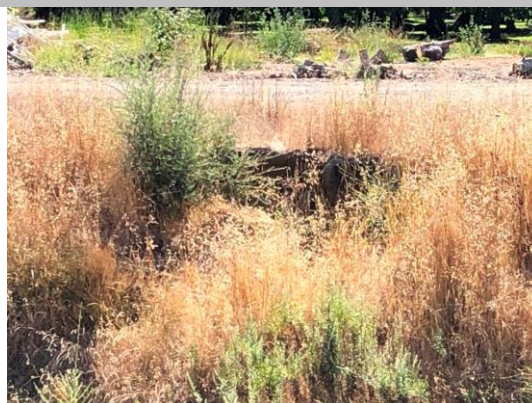
Photo 1 of 2 : SJR2019_DWR_NA0017_08_f _ 2018_134_1.JPG

LM Start	14.67	Rating **	M	Issue No.	152	
LM End	14.67	Issue Type +	Ma	Location *		
Category	Supplemental			GPS Latitude/Longitude		
				Start	End	
Item	DWR Erosion Survey			38.121103 °	38.121103 °	
				-121.169363 °	-121.169363 °	
DWR ID	NA0017U08RM21.46					
Comment Code						
Inspector Comment						
Site ID: NA0017U08RM21.46						
08/01/2019: Erosion likely has been caused by rainfall runoff.

Looking at the erosion from the right bank..

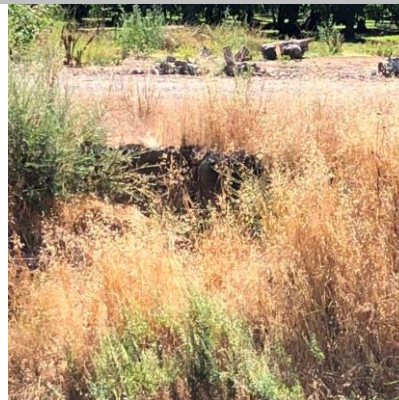
Photo 2 of 2 : SJR2019_DWR_NA0017_08_f_2018_134_3.JPG

LM Start	14.67	Rating **	M	Issue No.	152 (cont)	
LM End	14.67	Issue Type +	Ma	Location *		
Category	Supplemental			GPS Latitude/Longitude		
				Start		End
Item	DWR Erosion Survey			38.121103 °	38.121103 °	
				-121.169363 °	-121.169363 °	
DWR ID	NA0017U08RM21.46					
Comment Code						
Inspector Comment						
Site ID: NA0017U08RM21.46						
08/01/2019: Erosion likely has been caused by rainfall runoff.

Close view of the erosion.

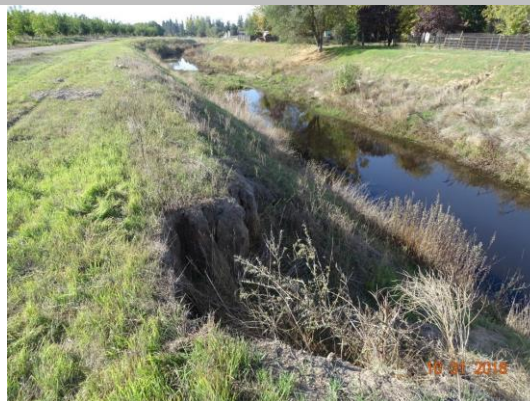
Photo 1 of 1 : FA_2019_NA0017_152_134_20190830_00025.jpg

LM Start	14.67	Rating **	M	Issue No.	134
LM End	14.67	Issue Type +	Ma	Location *	WS
Category	Earthen Levee			GPS Latitude/Longitude	
				Start	End
Item	Erosion / Bank Caving			38.121103 °	38.121103 °
				-121.169363 °	-121.169363 °
DWR ID	DWR_NA0017_08_f_2018_134				
Comment Code					
E2 : Schedule repair of erosion site prior to the next inspection.					
Inspector Comment					
There is erosion on the waterside slope.

View of erosion on the waterside slope. Fall 2018.

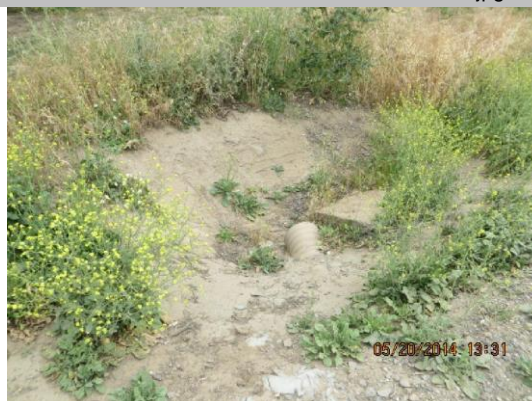
Photo 1 of 3 : UCIP_FA_2019_38127_69362.jpg

LM Start	14.70	Rating **	A/W	Issue No.	1193	
LM End	14.70	Issue Type +	Ma	Location *		
Category	Supplemental			GPS Latitude/Longitude		
				Start	End	
Item	DRAFT DWR UCIP LMA Responsibility			38.121425°	38.121425°	
				-121.169179°	-121.169179°	
DWR ID	23780					
Comment Code						
Inspector Comment						
DS_ID:23780						
FS_ID:38127						
EP_NO: N/A						
Repair Type: No Action Needed						
Crossing Status: Found						
UCIP Comments:						
FIELD_STRUCT_DESC: 12-inch corrugated metal drainage pipe through the levee, 3 feet below the crown. Flap gate on the waterside (WS) end. Cobble grouted spillway. Cobble grouted intake on the landside (LS). [Additional Reference(s): DWR Levee Log, 1990. USACE San Joaquin O&M Manual 612.2, 1967, (HLM 15.08)].						
FS Date: 5/20/2014

Pipe at LS toe.

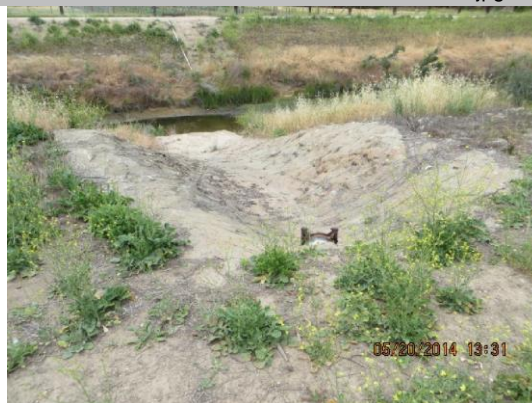
Photo 2 of 3 : UCIP_FA_2019_38127_69361.jpg

Pipe, flapgate, and grouted spillway on WS slope.

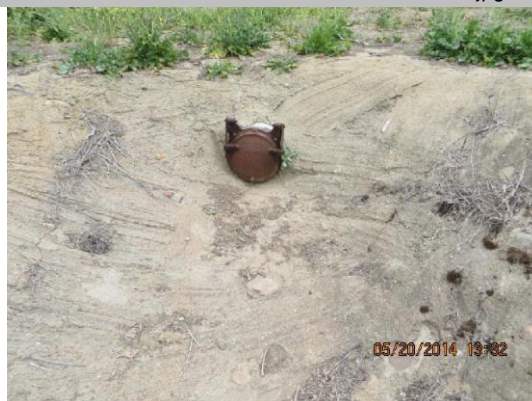
Photo 3 of 3 : UCIP_FA_2019_38127_69360.jpg

LM Start	14.70	Rating **	A/W	Issue No.	1193 (cont)	
LM End	14.70	Issue Type +	Ma	Location *		
Category	Supplemental			GPS Latitude/Longitude		
				Start	End	
Item	DRAFT DWR UCIP LMA Responsibility			38.121425°	38.121425°	
				-121.169179°	-121.169179°	
DWR ID	23780					
Comment Code						
Inspector Comment						
DS_ID:23780						
FS_ID:38127						
EP_NO: N/A						
Repair Type: No Action Needed						
Crossing Status: Found						
UCIP Comments:						
FIELD_STRUCT_DESC: 12-inch corrugated metal drainage pipe through the levee, 3 feet below the crown. Flap gate on the waterside (WS) end. Cobble grouted spillway. Cobble grouted intake on the landside (LS). [Additional Reference(s): DWR Levee Log, 1990. USACE San Joaquin O&M Manual 612.2, 1967, (HLM 15.08)].						
FS Date: 5/20/2014

Pipe, flapgate, and grouted spillway on WS slope.

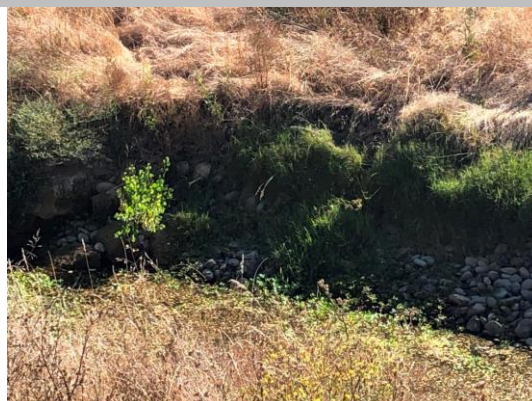
Photo 2 of 3 : SJR2019_DWR_NA0017_08_f_2015_57_2.JPG

LM Start	14.75	Rating **	M	Issue No.	173 (cont)	
LM End	14.76	Issue Type +	Ma	Location *		
Category	Supplemental			GPS Latitude/Longitude		
				Start	End	
Item	DWR Erosion Survey			38.122277 °	38.122277 °	
				-121.169031 °	-121.169031 °	
DWR ID	NA0017U08RM21.52					
Comment Code						
Inspector Comment						
Site ID: NA0017U08RM21.52						
08/01/2019: Erosion is at the bank toe, caused by river flow.

Close view of the erosion.

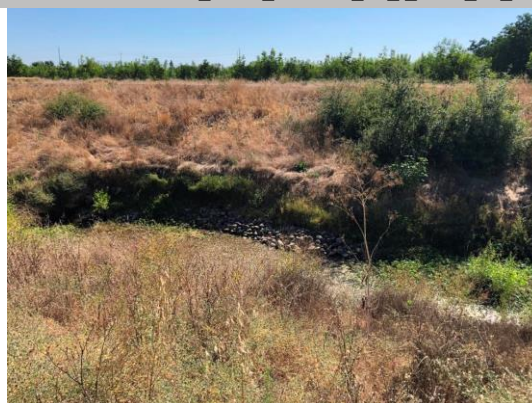
Photo 3 of 3 : SJR2019_DWR_NA0017_08_f_2015_57_4.JPG

Close-up view of the erosion.

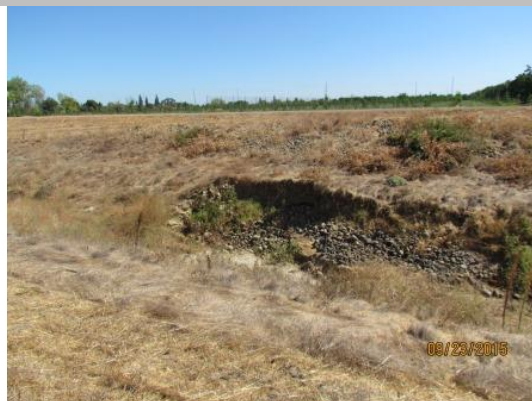
Photo 1 of 1 : FA_2019_NA0017_152_57_20190830_00007.jpg

LM Start	14.75	Rating **	M	Issue No.	57
LM End	14.75	Issue Type +	Ma	Location *	WS
Category	Earthen Levee			GPS Latitude/Longitude	
				Start	End
Item	Erosion / Bank Caving			38.122151 °	38.122151 °
				-121.169029 °	-121.169029 °
DWR ID	DWR_NA0017_08_f_2015_57				
Comment Code					
E2 : Schedule repair of erosion site prior to the next inspection.					
Inspector Comment					
There is waterside toe erosion at this location.

Erosion was found on the waterside toe of the levee. The picture was taken from the right bank of the levee.

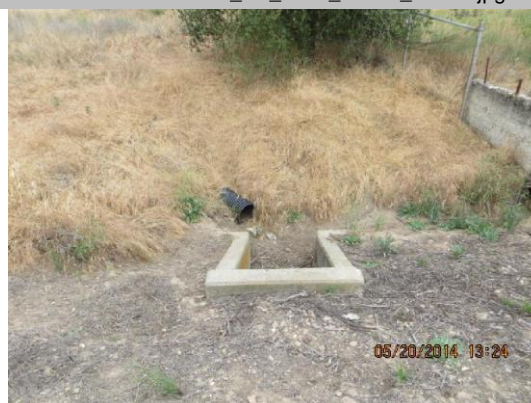
Photo 1 of 3 : UCIP_FA_2019_38126_69357.jpg

LM Start	14.85	Rating **	A/W	Issue No.	1194
LM End	14.85	Issue Type +	Ma	Location *	
Category	Supplemental			GPS Latitude/Longitude	
				Start	End
Item	DRAFT DWR UCIP LMA Responsibility			38.123628 °	38.123628 °
				-121.169175 °	-121.169175 °
DWR ID	23781				
Comment Code					
Inspector Comment					
DS_ID:23781					
FS_ID:38126					
EP_NO: N/A					
Repair Type: No Action Needed					
Crossing Status: Found					
UCIP Comments:					
FIELD_STRUCT_DESC: 24-inch corrugated metal drainage pipe through the levee, 6 feet below the crown. Concrete U-shaped headwall on both ends. Flap gate on the waterside (WS) end. Cobble grouted spillway. Cobble grouted inlet on the landside (LS). [Additional Reference(s): DWR Levee Log, 1990. USACE San Joaquin O&M Manual 612.2, 1967, (HLM 15.24)].					
FS Date: 5/20/2014

Headwall at LS toe.

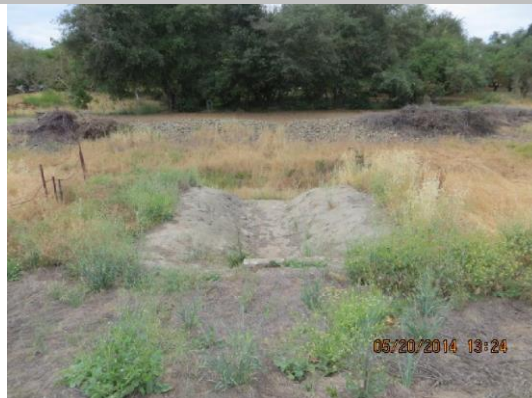
Photo 2 of 3 : UCIP_FA_2019_38126_69356.jpg

Headwall, flapgate, and grouted spillway on WS toe.

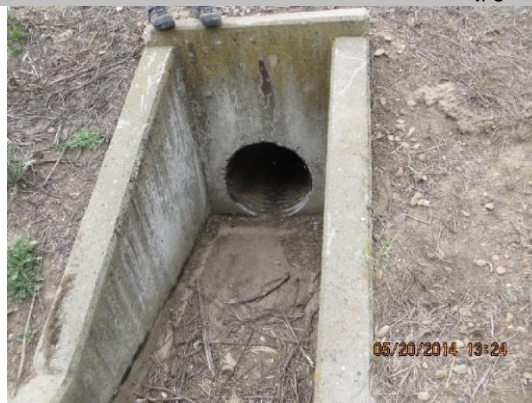
Photo 3 of 3 : UCIP_FA_2019_38126_69355.jpg

Headwall at LS toe.

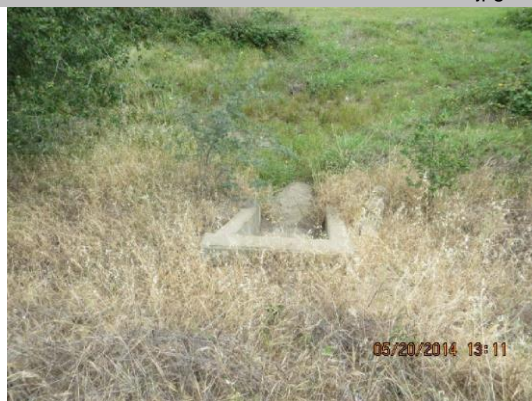
Photo 1 of 3 : UCIP_FA_2019_38125_69352.jpg

LM Start	15.05	Rating **	A/W	Issue No.	1196
LM End	15.05	Issue Type +	Ma	Location *	
Category	Supplemental			GPS Latitude/Longitude	
				Start	End
Item	DRAFT DWR UCIP LMA Responsibility			38.125741 °	38.125741 °
				-121.166840 °	-121.166840 °
DWR ID	23782				
Comment Code					
Inspector Comment					
DS_ID:23782					
FS_ID:38125					
EP_NO: N/A					
Repair Type: No Action Needed					
Crossing Status: Found					
UCIP Comments:					
FIELD_STRUCT_DESC: 24-inch corrugated metal drainage pipe through the levee, 6 feet below the crown. Concrete U-shaped headwall on both ends. Flap gate on the waterside (WS) end. Cobble grouted spillway. Cobble grouted intake on the landside (LS). [Additional Reference(s): DWR Levee Log, 1990. USACE San Joaquin O&M Manual 612.2, 1967, (HLM 15.44)].					
FS Date: 5/20/2014

Headwall at LS toe.

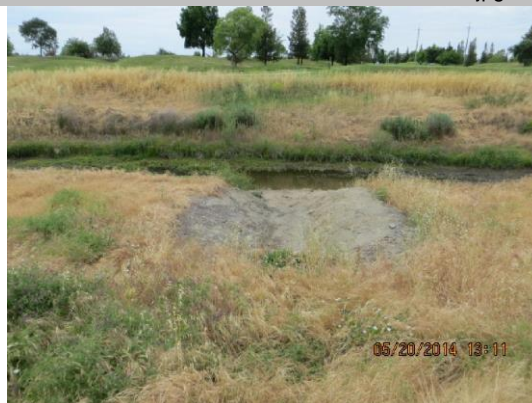
Photo 2 of 3 : UCIP_FA_2019_38125_69351.jpg

Headwall, flapgate, and grouted spillway on WS toe.

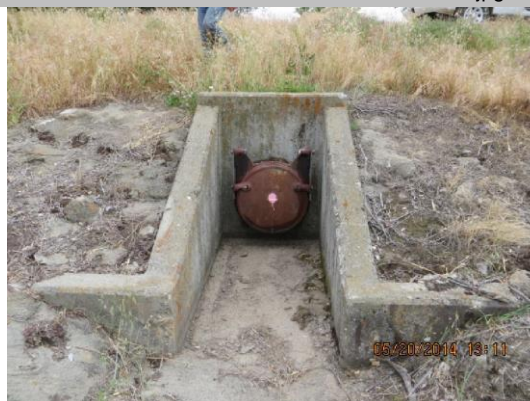
Photo 3 of 3 : UCIP_FA_2019_38125_69350.jpg

LM Start	15.05	Rating **	A/W	Issue No.	1196 (cont)	
LM End	15.05	Issue Type +	Ma	Location *		
Category	Supplemental			GPS Latitude/Longitude		
				Start		End
Item	DRAFT DWR UCIP LMA Responsibility			38.125741 °		38.125741 °
				-121.166840 °		-121.166840 °
DWR ID	23782					
Comment Code						
Inspector Comment						
DS_ID:23782						
FS_ID:38125						
EP_NO: N/A						
Repair Type: No Action Needed						
Crossing Status: Found						
UCIP Comments:						
FIELD_STRUCT_DESC: 24-inch corrugated metal drainage pipe through the levee, 6 feet below the crown. Concrete U-shaped headwall on both ends. Flap gate on the waterside (WS) end. Cobble grouted spillway. Cobble grouted intake on the landside (LS). [Additional Reference(s): DWR Levee Log, 1990. USACE San Joaquin O&M Manual 612.2, 1967, (HLM 15.44)].						
FS Date: 5/20/2014

Headwall and flapgate at WS toe.

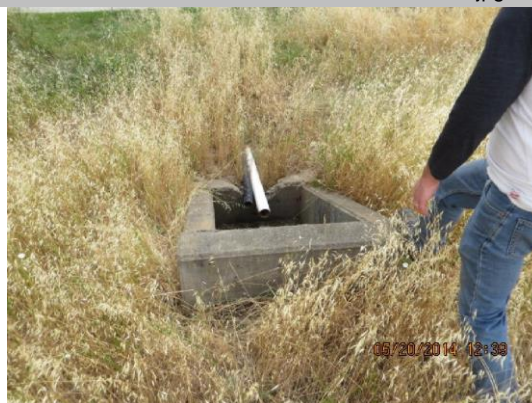
Photo 1 of 3 : UCIP_FA_2019_38122_69342.jpg

LM Start	15.62	Rating **	A/W	Issue No.	1204
LM End	15.62	Issue Type +	Ma	Location *	
Category	Supplemental			GPS Latitude/Longitude	
				Start	End
Item	DRAFT DWR UCIP LMA Responsibility			38.129880 °	38.129880 °
				-121.158017 °	-121.158017 °
DWR ID	23784				
Comment Code					
Inspector Comment					
DS_ID:23784 FS_ID:38122 EP_NO: N/A Repair Type: No Action Needed Crossing Status: Found UCIP Comments: FIELD_STRUCT_DESC: 24-inch corrugated metal drainage pipe through the levee, 3 feet below the crown. Concrete U-shaped headwall on both ends. Flap gate on the waterside (WS) end. Cobble grouted spillway. Cobble grouted intake on the landside (LS). [Additional Reference(s): DWR Levee Log, 1990. USACE San Joaquin O&M Manual 612.2, 1967, (HLM 16.02)]. FS Date: 5/20/2014

Headwall on LS toe.

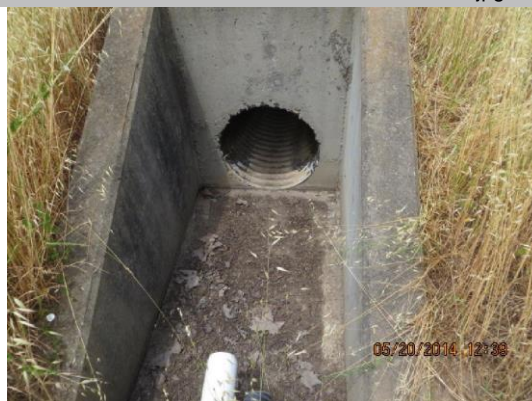
Photo 2 of 3 : UCIP_FA_2019_38122_69341.jpg

LM Start	15.62	Rating **	A/W	Issue No.	1204 (cont)	
LM End	15.62	Issue Type +	Ma	Location *		
Category	Supplemental			GPS Latitude/Longitude		
				Start		End
Item	DRAFT DWR UCIP LMA Responsibility			38.129880 °		38.129880 °
				-121.158017 °		-121.158017 °
DWR ID	23784					
Comment Code						
Inspector Comment						
DS_ID:23784 FS_ID:38122 EP_NO: N/A Repair Type: No Action Needed Crossing Status: Found UCIP Comments: FIELD_STRUCT_DESC: 24-inch corrugated metal drainage pipe through the levee, 3 feet below the crown. Concrete U-shaped headwall on both ends. Flap gate on the waterside (WS) end. Cobble grouted spillway. Cobble grouted intake on the landside (LS). [Additional Reference(s): DWR Levee Log, 1990. USACE San Joaquin O&M Manual 612.2, 1967, (HLM 16.02)]. FS Date: 5/20/2014

Headwall on LS toe.

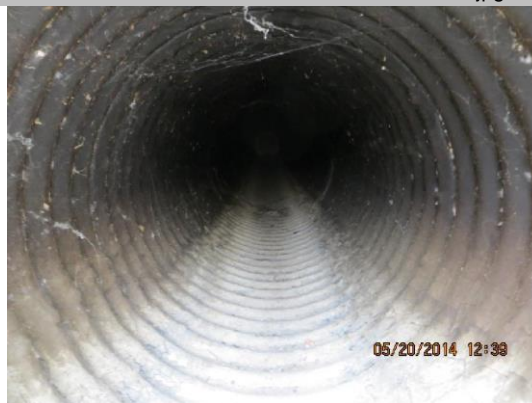
Photo 3 of 3 : UCIP_FA_2019_38122_69340.jpg

Inside pipe at LS toe.

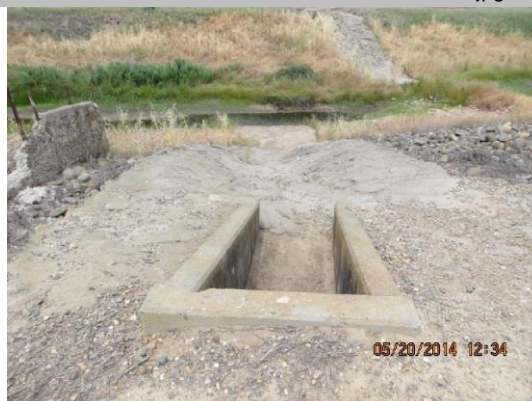
Photo 1 of 3 : UCIP_FA_2019_38121_69337.jpg

LM Start	15.75	Rating **	A/W	Issue No.	1205	
LM End	15.75	Issue Type +	Ma	Location *		
Category	Supplemental			GPS Latitude/Longitude		
				Start		End
Item	DRAFT DWR UCIP LMA Responsibility			38.129962 °		38.129962 °
				-121.155657 °		-121.155657 °
DWR ID	23785					
Comment Code						
Inspector Comment						
DS_ID:23785						
FS_ID:38121						
EP_NO: N/A						
Repair Type: No Action Needed						
Crossing Status: Found						
UCIP Comments:						
FIELD_STRUCT_DESC: 24-inch corrugated metal drainage pipe through the levee, 1.5 feet below the crown. Concrete U-shaped headwall on both ends. Flap gate on the waterside (WS) end. Cobble grouted spillway. Cobble grouted intake on the landside (LS). [Additional Reference(s): DWR Levee Log, 1990. USACE San Joaquin O&M Manual 612.2, 1967, (HLM 16.15)].						
FS Date: 5/20/2014

Headwall, flapgate, and grouted spillway on WS slope.

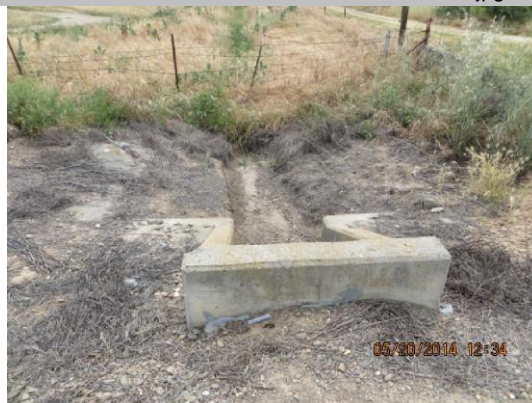
Photo 2 of 3 : UCIP_FA_2019_38121_69336.jpg

Headwall on LS toe.

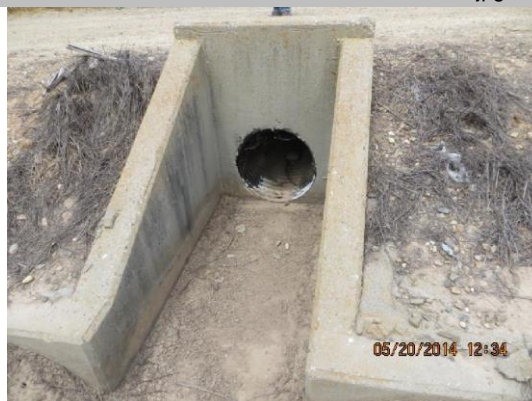
Photo 3 of 3 : UCIP_FA_2019_38121_69335.jpg

LM Start	15.75	Rating **	A/W	Issue No.	1205 (cont)	
LM End	15.75	Issue Type +	Ma	Location *		
Category	Supplemental			GPS Latitude/Longitude		
				Start	End	
Item	DRAFT DWR UCIP LMA Responsibility			38.129962 °	38.129962 °	
				-121.155657 °	-121.155657 °	
DWR ID	23785					
Comment Code						
Inspector Comment						
DS_ID:23785						
FS_ID:38121						
EP_NO: N/A						
Repair Type: No Action Needed						
Crossing Status: Found						
UCIP Comments:						
FIELD_STRUCT_DESC: 24-inch corrugated metal drainage pipe through the levee, 1.5 feet below the crown. Concrete U-shaped headwall on both ends. Flap gate on the waterside (WS) end. Cobble grouted spillway. Cobble grouted intake on the landside (LS). [Additional Reference(s): DWR Levee Log, 1990. USACE San Joaquin O&M Manual 612.2, 1967, (HLM 16.15)].						
FS Date: 5/20/2014

Headwall on LS toe.

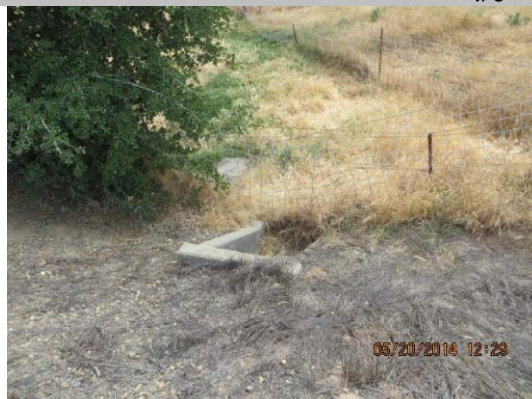
Photo 1 of 3 : UCIP_FA_2019_38120_69333.jpg

LM Start	15.82	Rating **	A/W	Issue No.	1206
LM End	15.82	Issue Type +	Ma	Location *	
Category	Supplemental			GPS Latitude/Longitude	
				Start	End
Item	DRAFT DWR UCIP LMA Responsibility			38.130425 °	38.130425 °
				-121.154574 °	-121.154574 °
DWR ID	23786				
Comment Code					
Inspector Comment					
DS_ID:23786 FS_ID:38120 EP_NO: N/A Repair Type: No Action Needed Crossing Status: Found UCIP Comments: FIELD_STRUCT_DESC: 24-inch corrugated metal drainage pipe through the levee, 8 feet below the crown. Concrete U-shaped headwall on both ends. Flap gate on the waterside (WS) end. Cobble grouted spillway. Cobble grouted intake on the landside (LS). [Additional Reference(s): DWR Levee Log, 1990. USACE San Joaquin O&M Manual 612.2, 1967, (HLM 16.22)]. FS Date: 5/20/2014

Headwall at LS toe.

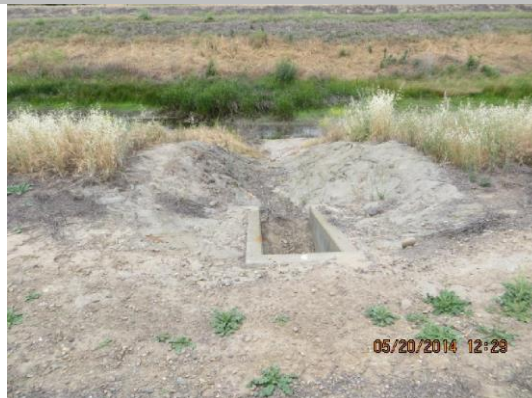
Photo 2 of 3 : UCIP_FA_2019_38120_69332.jpg

LM Start	15.82	Rating **	A/W	Issue No.	1206 (cont)	
LM End	15.82	Issue Type +	Ma	Location *		
Category	Supplemental			GPS Latitude/Longitude		
				Start		End
Item	DRAFT DWR UCIP LMA Responsibility			38.130425 °		38.130425 °
				-121.154574 °		-121.154574 °
DWR ID	23786					
Comment Code						
Inspector Comment						
DS_ID:23786 FS_ID:38120 EP_NO: N/A Repair Type: No Action Needed Crossing Status: Found UCIP Comments: FIELD_STRUCT_DESC: 24-inch corrugated metal drainage pipe through the levee, 8 feet below the crown. Concrete U-shaped headwall on both ends. Flap gate on the waterside (WS) end. Cobble grouted spillway. Cobble grouted intake on the landside (LS). [Additional Reference(s): DWR Levee Log, 1990. USACE San Joaquin O&M Manual 612.2, 1967, (HLM 16.22)]. FS Date: 5/20/2014

Headwall and flapgate at WS toe.

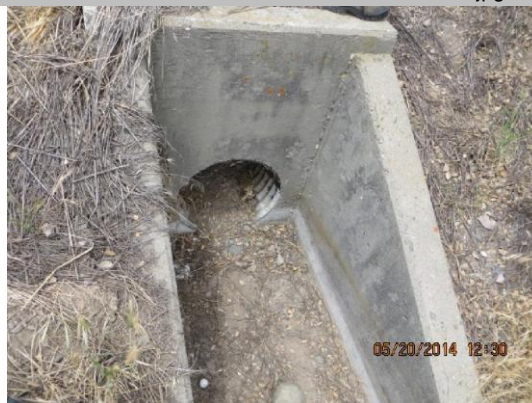
Photo 3 of 3 : UCIP_FA_2019_38120_69331.jpg

Headwall at LS toe.

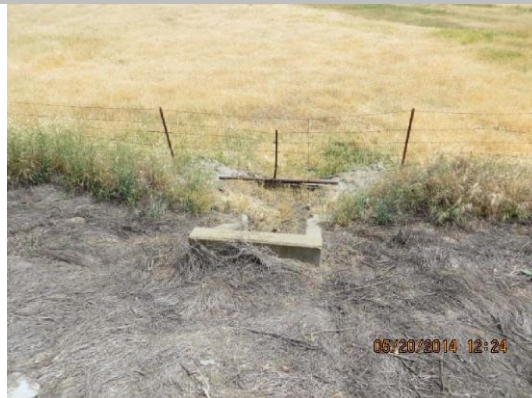
Photo 1 of 3 : UCIP_FA_2019_38119_69328.jpg

LM Start	15.88	Rating **	A/W	Issue No.	1207
LM End	15.88	Issue Type +	Ma	Location *	
Category	Supplemental			GPS Latitude/Longitude	
				Start	End
Item	DRAFT DWR UCIP LMA Responsibility			38.131106°	38.131106°
				-121.153977°	-121.153977°
DWR ID	23787				
Comment Code					
Inspector Comment					
DS_ID:23787 FS_ID:38119 EP_NO: N/A Repair Type: No Action Needed Crossing Status: Found UCIP Comments: FIELD_STRUCT_DESC: 24-inch corrugated metal drainage pipe through the levee, 6 feet below the crown. Concrete U-shaped headwall on both ends. Flap gate on the waterside (WS) end. Cobble grouted spillway. Cobble grouted intake on the landside (LS). [Additional Reference(s): DWR Levee Log, 1990. USACE San Joaquin O&M Manual 612.2, 1967, (HLM 16.27)]. FS Date: 5/20/2014

Concrete headwall on LS toe.

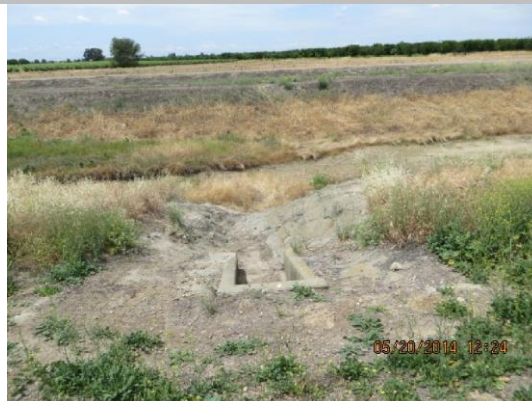
Photo 2 of 3 : UCIP_FA_2019_38119_69327.jpg

Flapgate and headwall on WS toe.

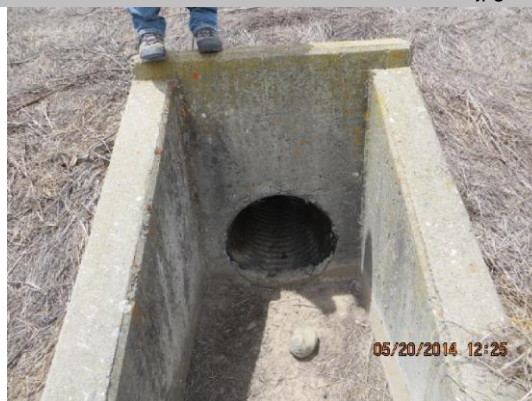
Photo 3 of 3 : UCIP_FA_2019_38119_69326.jpg

LM Start	15.88	Rating **	A/W	Issue No.	1207 (cont)	
LM End	15.88	Issue Type +	Ma	Location *		
Category	Supplemental			GPS Latitude/Longitude		
				Start		End
Item	DRAFT DWR UCIP LMA Responsibility			38.131106 °		38.131106 °
				-121.153977 °		-121.153977 °
DWR ID	23787					
Comment Code						
Inspector Comment						
DS_ID:23787						
FS_ID:38119						
EP_NO: N/A						
Repair Type: No Action Needed						
Crossing Status: Found						
UCIP Comments:						
FIELD_STRUCT_DESC: 24-inch corrugated metal drainage pipe through the levee, 6 feet below the crown. Concrete U-shaped headwall on both ends. Flap gate on the waterside (WS) end. Cobble grouted spillway. Cobble grouted intake on the landside (LS). [Additional Reference(s): DWR Levee Log, 1990. USACE San Joaquin O&M Manual 612.2, 1967, (HLM 16.27)].						
FS Date: 5/20/2014

Concrete headwall on LS toe.

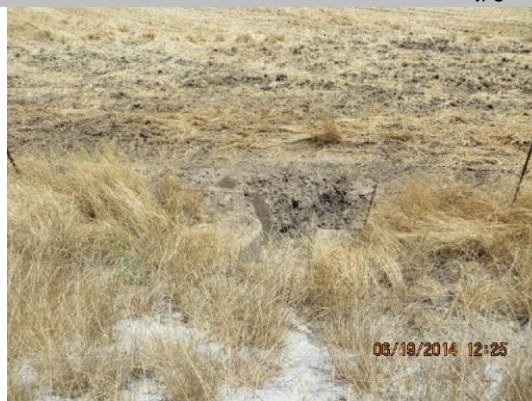
Photo 1 of 3 : UCIP_FA_2019_38975_71120.jpg

Comment Code					
Inspector Comment					
DS_ID:23850 FS_ID:38975 EP_NO: N/A Repair Type: No Action Needed Crossing Status: Found UCIP Comments: FIELD_STRUCT_DESC: 24-inch CM drainage pipe through the levee, 9.5-feet below the crown. Concrete "U" headwall on both ends. Flap gate on the waterward end. Cobble grouted spillway. Cobble grouted intake on the landward side. O&M Manual Bear Creek Part 2, 1967. Included in O&M Manual Bear Creek Addendum, February 1999. [Additional Reference(s): DWR Levee Log, 1977, 1978, 1987, 1990. USACE San Joaquin O&M Manual Unit 612, Part No. 2 - Bear Creel Project, Unit 7: HLM 7.19 – 16.77, Unit 8: HLM 7.55-16.48, Unit 9: HLM 0.10-1.52; Unit 10: HLM 0.03-1.35, Unit 11: HLM 0.16-3.55, Unit 12: HLM 0.14-3.91; Unit 13, HLM 0.03-1.18; Unit 14, HLM 0.02-1.17, 1967, (HLM 1.52)] FS Date: 6/19/2014

Pipe and headwall on LS toe.

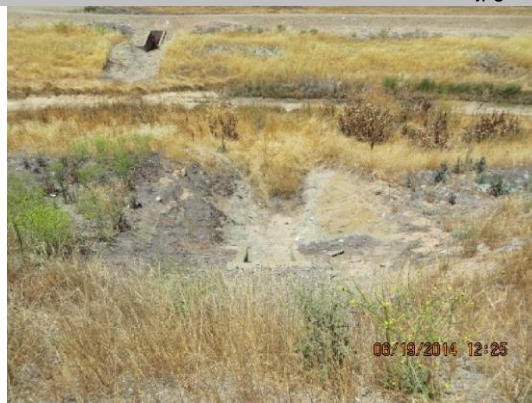
Photo 2 of 3 : UCIP_FA_2019_38975_71119.jpg

Pipe, flapgate, and grouted spillway on WS slope.

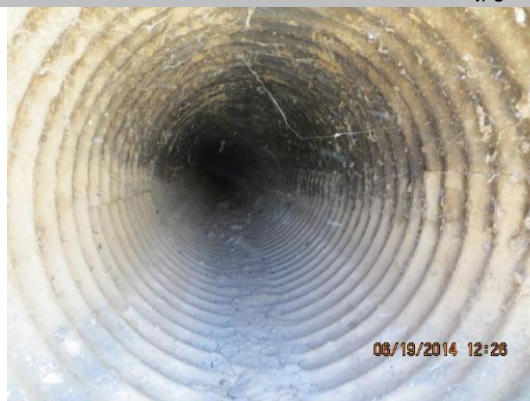
Photo 3 of 3 : UCIP_FA_2019_38975_71123.jpg

Comment Code						
Inspector Comment						
DS_ID:23850 FS_ID:38975 EP_NO: N/A Repair Type: No Action Needed Crossing Status: Found UCIP Comments: FIELD_STRUCT_DESC: 24-inch CM drainage pipe through the levee, 9.5-feet below the crown. Concrete "U" headwall on both ends. Flap gate on the waterward end. Cobble grouted spillway. Cobble grouted intake on the landward side. O&M Manual Bear Creek Part 2, 1967. Included in O&M Manual Bear Creek Addendum, February 1999. [Additional Reference(s): DWR Levee Log, 1977, 1978, 1987, 1990. USACE San Joaquin O&M Manual Unit 612, Part No. 2 - Bear Creel Project, Unit 7: HLM 7.19 – 16.77, Unit 8: HLM 7.55-16.48, Unit 9: HLM 0.10-1.52; Unit 10: HLM 0.03-1.35, Unit 11: HLM 0.16-3.55, Unit 12: HLM 0.14-3.91; Unit 13, HLM 0.03-1.18; Unit 14, HLM 0.02-1.17, 1967, (HLM 1.52)] FS Date: 6/19/2014

Inside pipe at LS toe.

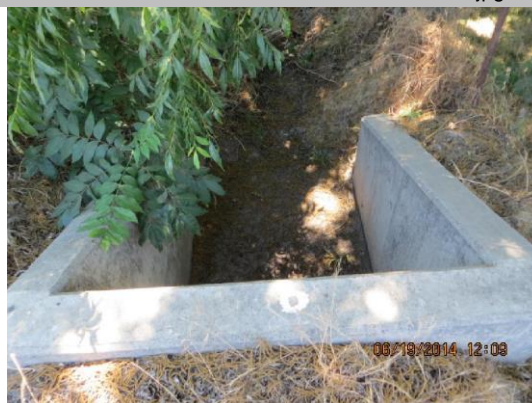
Photo 1 of 3 : UCIP_FA_2019_38973_71110.jpg

LM Start	0.55	Rating **	A/W	Issue No.	19
LM End	0.55	Issue Type +	Ma	Location *	
Category	Supplemental			GPS Latitude/Longitude	
				Start	End
Item	DRAFT DWR UCIP LMA Responsibility			38.094855 °	38.094855 °
				-121.166867 °	-121.166867 °
DWR ID	23853				
Comment Code					
Inspector Comment					
DS_ID:23853 FS_ID:38973 EP_NO: N/A Repair Type: No Action Needed Crossing Status: Found UCIP Comments: FIELD_STRUCT_DESC: 24-inch corrugated metal drainage pipe through the levee, 4.5 feet below the crown. Flap gate on the waterside (WS) end. Concrete U-shaped headwall on both ends. Cobble grouted spillway. Cobble grouted intake on the landside (LS). [Additional Reference(s): DWR Levee Log, 1987. USACE San Joaquin O&M Manual 612.2, 1967, (HLM 0.56)]. FS Date: 6/19/2014

Pipe and headwall on LS toe.

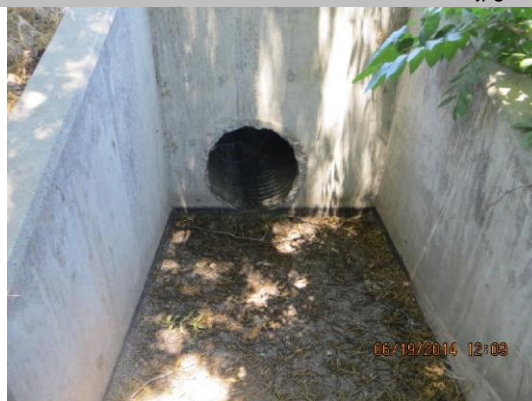
Photo 2 of 3 : UCIP_FA_2019_38973_71109.jpg

LM Start	0.55	Rating **	A/W	Issue No.	19 (cont)	
LM End	0.55	Issue Type +	Ma	Location *		
Category	Supplemental			GPS Latitude/Longitude		
				Start		End
Item	DRAFT DWR UCIP LMA Responsibility			38.094855 °		38.094855 °
				-121.166867 °		-121.166867 °
DWR ID	23853					
Comment Code						
Inspector Comment						
DS_ID:23853 FS_ID:38973 EP_NO: N/A Repair Type: No Action Needed Crossing Status: Found UCIP Comments: FIELD_STRUCT_DESC: 24-inch corrugated metal drainage pipe through the levee, 4.5 feet below the crown. Flap gate on the waterside (WS) end. Concrete U-shaped headwall on both ends. Cobble grouted spillway. Cobble grouted intake on the landside (LS). [Additional Reference(s): DWR Levee Log, 1987. USACE San Joaquin O&M Manual 612.2, 1967, (HLM 0.56)]. FS Date: 6/19/2014

Pipe and headwall on LS toe.

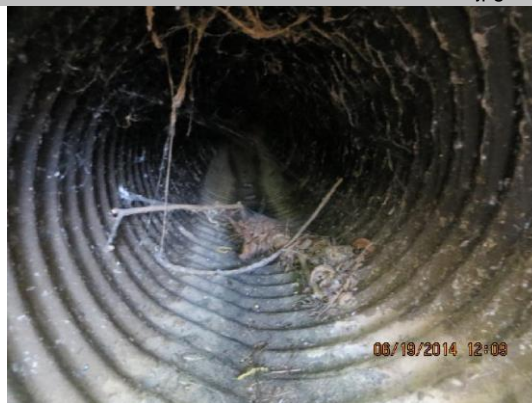
Photo 3 of 3 : UCIP_FA_2019_38973_71108.jpg

Inside pipe at LS toe.

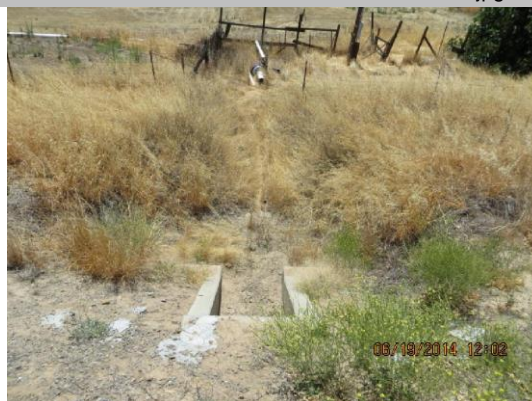
Photo 1 of 3 : UCIP_FA_2019_38972_71105.jpg

Comment Code					
Inspector Comment					
DS_ID:23839 FS_ID:38972 EP_NO: N/A Repair Type: No Action Needed Crossing Status: Found UCIP Comments: Suction hose and appurtances appear to be abandoned. FIELD_STRUCT_DESC: 24-inch corrugated metal drainage pipe through the levee, 8 feet below the crown. Concrete U-shaped headwall on both ends. Flap gate on the waterside (WS) end. Cobble grouted spillway. Cobble grouted intake on the landside (LS). Pump with suction hose sleeved through storm drainage pipe located on the LS, removed during winter months. (Suction hose sleeved through pipe under Permit No. 11530, 1976 - Constantine M. Coppulos). [Additional Reference(s): DWR Levee Log, 1987. USACE San Joaquin O&M Manual 612.2, 1967, (HLM 0.62) and 612 (addendum), February 1999, (HLM 0.61) (Station 32+46)]. FS Date: 6/19/2014

Pipe and headwall on LS toe.

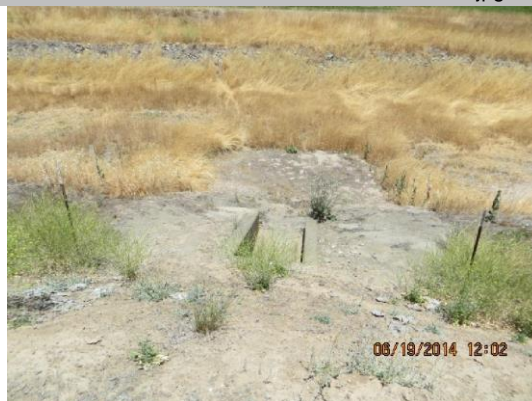
Photo 2 of 3 : UCIP_FA_2019_38972_71104.jpg

Pipe, flapgate, and grouted spillway on WS slope.

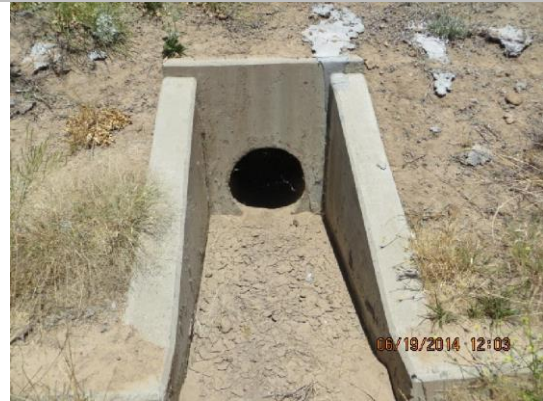
Photo 3 of 3 : UCIP_FA_2019_38972_71103.jpg

Comment Code					
Inspector Comment					
DS_ID:23839 FS_ID:38972 EP_NO: N/A Repair Type: No Action Needed Crossing Status: Found UCIP Comments: Suction hose and appurtances appear to be abandoned. FIELD_STRUCT_DESC: 24-inch corrugated metal drainage pipe through the levee, 8 feet below the crown. Concrete U-shaped headwall on both ends. Flap gate on the waterside (WS) end. Cobble grouted spillway. Cobble grouted intake on the landside (LS). Pump with suction hose sleeved through storm drainage pipe located on the LS, removed during winter months. (Suction hose sleeved through pipe under Permit No. 11530, 1976 - Constantine M. Coppulos). [Additional Reference(s): DWR Levee Log, 1987. USACE San Joaquin O&M Manual 612.2, 1967, (HLM 0.62) and 612 (addendum), February 1999, (HLM 0.61) (Station 32+46)]. FS Date: 6/19/2014

Pipe and headwall on LS toe.

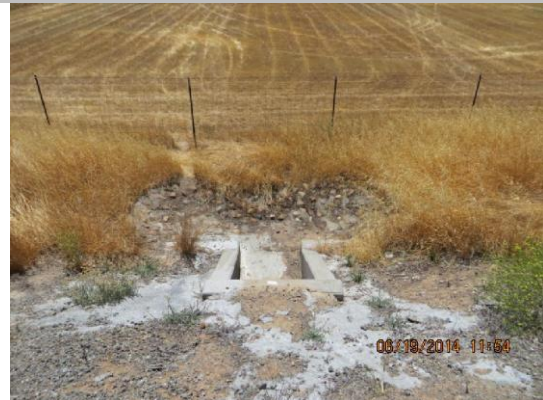
Photo 1 of 3 : UCIP_FA_2019_38971_71100.jpg

LM Start	0.85	Rating **	A/W	Issue No.	21
LM End	0.85	Issue Type +	Ma	Location *	
Category	Supplemental			GPS Latitude/Longitude	
				Start	End
Item	DRAFT DWR UCIP LMA Responsibility			38.094220 °	38.094220 °
				-121.161651 °	-121.161651 °
DWR ID	23840				
Comment Code					
Inspector Comment					
DS_ID:23840 FS_ID:38971 EP_NO: N/A Repair Type: No Action Needed Crossing Status: Found UCIP Comments: FIELD_STRUCT_DESC: 24-inch corrugated metal drainage pipe through the levee, 7 feet below the crown. Concrete U-shaped headwall on both ends. Flap gate on the waterside (WS) end. Cobble grouted spillway. Cobble grouted intake on the landside (LS). [Additional Reference(s): DWR Levee Log, 1987. USACE San Joaquin O&M Manual 612.2, 1967, (HLM 0.86)]. FS Date: 6/19/2014

Pipe and headwall on LS toe.

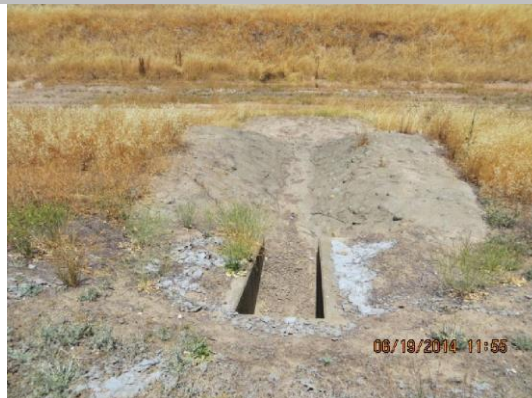
Photo 2 of 3 : UCIP_FA_2019_38971_71099.jpg

LM Start	0.85	Rating **	A/W	Issue No.	21 (cont)	
LM End	0.85	Issue Type +	Ma	Location *		
Category	Supplemental			GPS Latitude/Longitude		
				Start		End
Item	DRAFT DWR UCIP LMA Responsibility			38.094220 °		38.094220 °
				-121.161651 °		-121.161651 °
DWR ID	23840					
Comment Code						
Inspector Comment						
DS_ID:23840 FS_ID:38971 EP_NO: N/A Repair Type: No Action Needed Crossing Status: Found UCIP Comments: FIELD_STRUCT_DESC: 24-inch corrugated metal drainage pipe through the levee, 7 feet below the crown. Concrete U-shaped headwall on both ends. Flap gate on the waterside (WS) end. Cobble grouted spillway. Cobble grouted intake on the landside (LS). [Additional Reference(s): DWR Levee Log, 1987. USACE San Joaquin O&M Manual 612.2, 1967, (HLM 0.86)]. FS Date: 6/19/2014

Pipe, flapgate, and grouted spillway on WS slope.

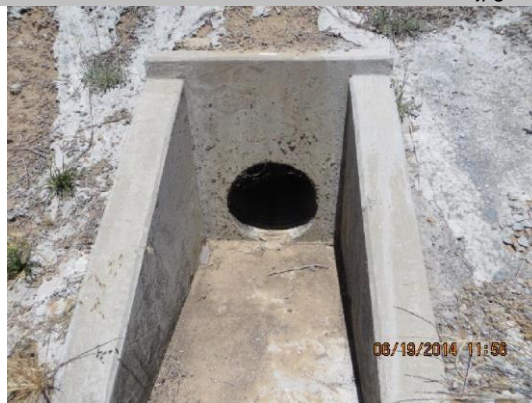
Photo 3 of 3 : UCIP_FA_2019_38971_71098.jpg

Pipe and headwall on LS toe.

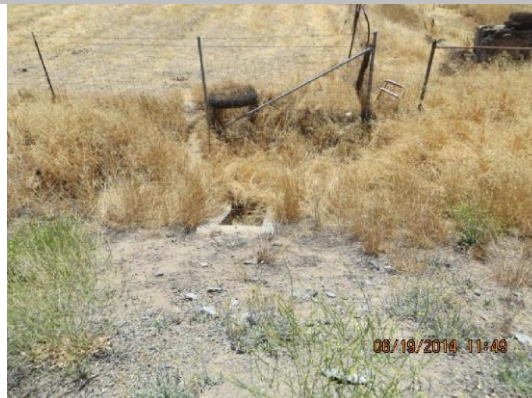
Photo 1 of 3 : UCIP_FA_2019_41812_71095.jpg

LM Start	0.93	Rating **	M	Issue No.	22
LM End	0.93	Issue Type +	Ma	Location *	
Category	Supplemental			GPS Latitude/Longitude	
				Start	End
Item	DRAFT DWR UCIP LMA Responsibility			38.094247 °	38.094247 °
				-121.160271 °	-121.160271 °
DWR ID	23841				
Comment Code					
Inspector Comment					
DS_ID:23841					
FS_ID:41812					
EP_NO: N/A					
Repair Type: Non-Urgent					
Crossing Status: Found					
UCIP Comments: Sediment buildup inside pipe.					
FIELD_STRUCT_DESC: 12-inch corrugated metal storm drainage pipe through the levee, 7 feet below the crown. Headwall on the landside (LS) toe. Flap gate on the waterside (WS) end. Cobble grouted spillway. [Additional Reference(s): DWR Levee Log, 1987. USACE San Joaquin O&M Manual 612 (addendum), February 1999, (HLM 0.93) (Station 49+30)].					
FS Date: 6/19/2014

Pipe and headwall on LS toe.

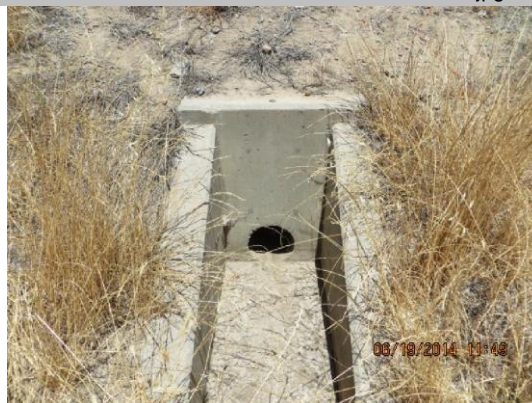
Photo 2 of 3 : UCIP_FA_2019_41812_71094.jpg

Pipe and headwall on LS toe.

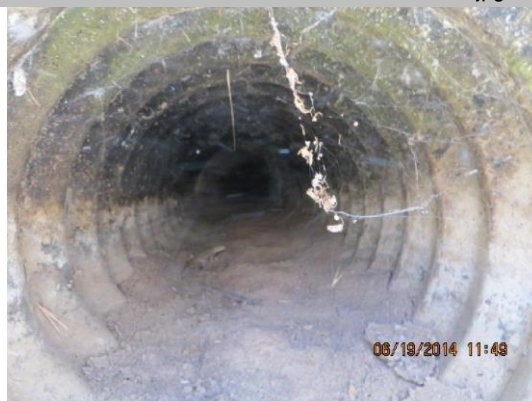
Photo 3 of 3 : UCIP_FA_2019_41812_71093.jpg

LM Start	0.93	Rating **	M	Issue No.	22 (cont)	
LM End	0.93	Issue Type +	Ma	Location *		
Category	Supplemental			GPS Latitude/Longitude		
				Start		End
Item	DRAFT DWR UCIP LMA Responsibility			38.094247 °		38.094247 °
				-121.160271 °		-121.160271 °
DWR ID	23841					
Comment Code						
Inspector Comment						
DS_ID:23841						
FS_ID:41812						
EP_NO: N/A						
Repair Type: Non-Urgent						
Crossing Status: Found						
UCIP Comments: Sediment buildup inside pipe.						
FIELD_STRUCT_DESC: 12-inch corrugated metal storm drainage pipe through the levee, 7 feet below the crown. Headwall on the landside (LS) toe. Flap gate on the waterside (WS) end. Cobble grouted spillway. [Additional Reference(s): DWR Levee Log, 1987. USACE San Joaquin O&M Manual 612 (addendum), February 1999, (HLM 0.93) (Station 49+30)].						
FS Date: 6/19/2014

Inside pipe at LS toe.

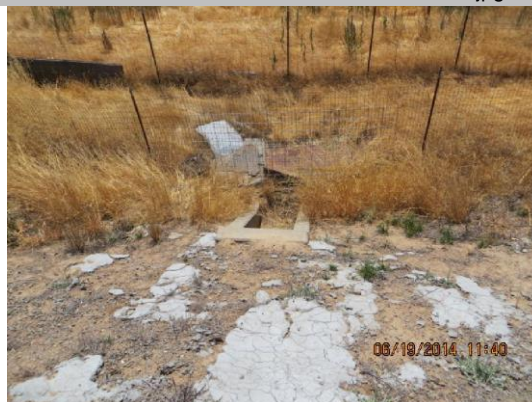
Photo 1 of 3 : UCIP_FA_2019_38969_71090.jpg

LM Start	1.02	Rating **	A/W	Issue No.	23
LM End	1.02	Issue Type +	Ma	Location *	
Category	Supplemental			GPS Latitude/Longitude	
				Start	End
Item	DRAFT DWR UCIP LMA Responsibility			38.094287 °	38.094287 °
				-121.158599 °	-121.158599 °
DWR ID	23842				
Comment Code					
Inspector Comment					
DS_ID:23842					
FS_ID:38969					
EP_NO: N/A					
Repair Type: No Action Needed					
Crossing Status: Found					
UCIP Comments:					
FIELD_STRUCT_DESC: 12-inch corrugated metal drainage pipe through the levee, 6 feet below the crown. Flap gate on the waterside (WS) end. Cobble grouted spillway. [Additional Reference(s): DWR Levee Log, 1987. USACE San Joaquin O&M Manual 612.2, 1967, (HLM 1.03)].					
FS Date: 6/19/2014

Pipe and headwall on LS toe.

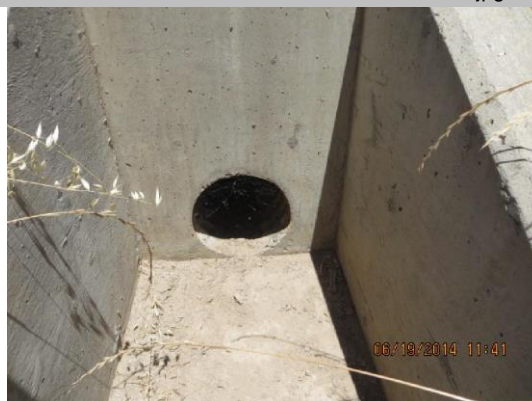
Photo 2 of 3 : UCIP_FA_2019_38969_71089.jpg

LM Start	1.02	Rating **	A/W	Issue No.	23 (cont)	
LM End	1.02	Issue Type +	Ma	Location *		
Category	Supplemental			GPS Latitude/Longitude		
				Start	End	
Item	DRAFT DWR UCIP LMA Responsibility			38.094287 °	38.094287 °	
				-121.158599 °	-121.158599 °	
DWR ID	23842					
Comment Code						
Inspector Comment						
DS_ID:23842 FS_ID:38969 EP_NO: N/A Repair Type: No Action Needed Crossing Status: Found UCIP Comments: FIELD_STRUCT_DESC: 12-inch corrugated metal drainage pipe through the levee, 6 feet below the crown. Flap gate on the waterside (WS) end. Cobble grouted spillway. [Additional Reference(s): DWR Levee Log, 1987. USACE San Joaquin O&M Manual 612.2, 1967, (HLM 1.03)]. FS Date: 6/19/2014

Pipe and headwall on LS toe.

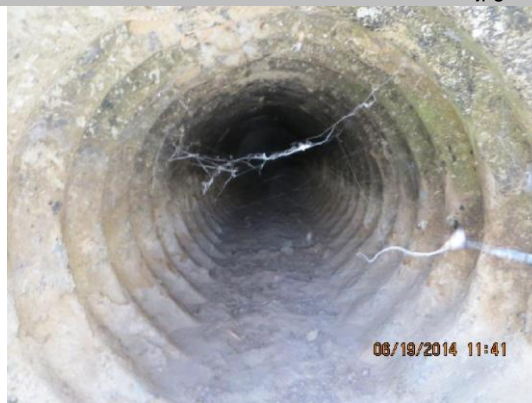
Photo 3 of 3 : UCIP_FA_2019_38969_71088.jpg

Inside pipe at LS toe.

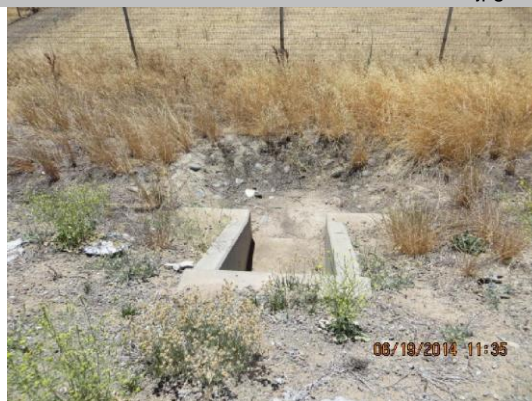
Photo 1 of 3 : UCIP_FA_2019_38968_71085.jpg

LM Start	1.08	Rating **	A/W	Issue No.	24
LM End	1.08	Issue Type +	Ma	Location *	
Category	Supplemental			GPS Latitude/Longitude	
				Start	End
Item	DRAFT DWR UCIP LMA Responsibility			38.094318 °	38.094318 °
				-121.157487 °	-121.157487 °
DWR ID	23843				
Comment Code					
Inspector Comment					
DS_ID:23843 FS_ID:38968 EP_NO: N/A Repair Type: No Action Needed Crossing Status: Found UCIP Comments: FIELD_STRUCT_DESC: 24-inch corrugated metal drainage pipe through the levee, 4.5 feet below the crown. Concrete U-shaped headwall on both ends. Flap gate on the waterside (WS) end. One corrugated metal cutoff wall. Cobble grouted spillway. Cobble grouted intake on the landside (LS). [Additional Reference(s): DWR Levee Log, 1987. USACE San Joaquin O&M Manual 612.2, 1967, (HLM 1.09) and 612 (addendum), February 1999, (HLM 1.09) (Station 57+30)]. FS Date: 6/19/2014

Headwall at LS toe.

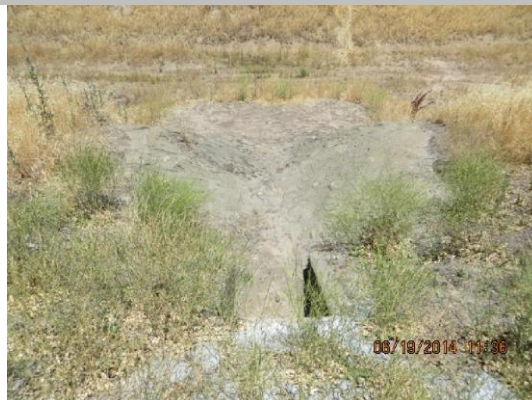
Photo 2 of 3 : UCIP_FA_2019_38968_71084.jpg

Pipe, flapgate, and grouted spillway on WS toe.

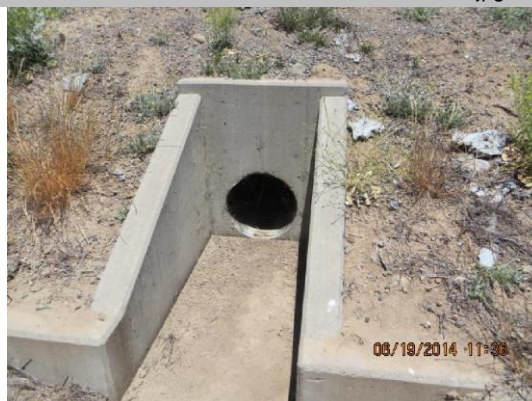
Photo 3 of 3 : UCIP_FA_2019_38968_71083.jpg

Headwall at LS toe.

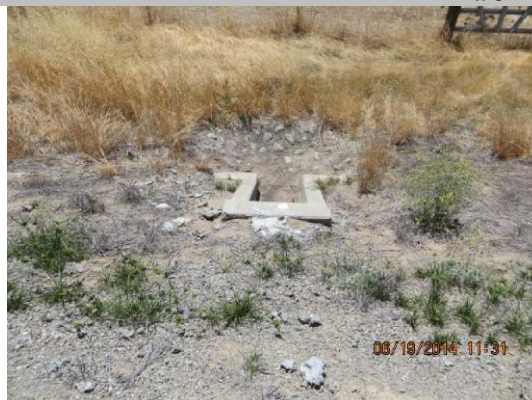
Photo 1 of 3 : UCIP_FA_2019_38967_71079.jpg

LM Start	1.16	Rating **	A/W	Issue No.	25
LM End	1.16	Issue Type +	Ma	Location *	
Category	Supplemental			GPS Latitude/Longitude	
				Start	End
Item	DRAFT DWR UCIP LMA Responsibility			38.094356 °	38.094356 °
				-121.155924 °	-121.155924 °
DWR ID	23844				
Comment Code					
Inspector Comment					
DS_ID:23844 FS_ID:38967 EP_NO: N/A Repair Type: No Action Needed Crossing Status: Found UCIP Comments: FIELD_STRUCT_DESC: 12-inch corrugated metal drainage pipe through the levee, 7 feet below the crown. Headwall on the landside (LS) toe. Flap gate on the waterside (WS) end. Cobble grouted spillway. [Additional Reference(s): DWR Levee Log, 1987. USACE San Joaquin O&M Manual 612.2, 1967, (HLM 1.18) and 612 (addendum), February 1999, (HLM 1.17) (Station 61+82)]. FS Date: 6/19/2014

Pipe and headwall on LS toe.

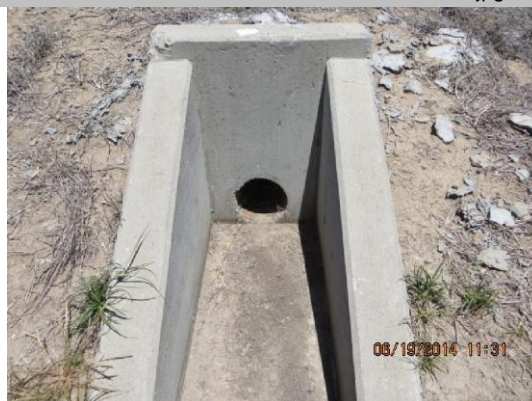
Photo 2 of 3 : UCIP_FA_2019_38967_71078.jpg

Pipe and headwall on LS toe.

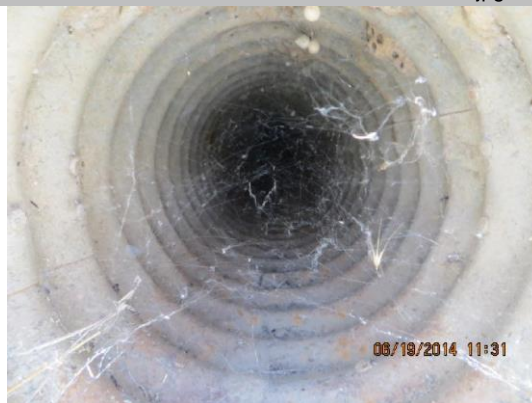
Photo 3 of 3 : UCIP_FA_2019_38967_71082.jpg

Inside pipe at LS toe.

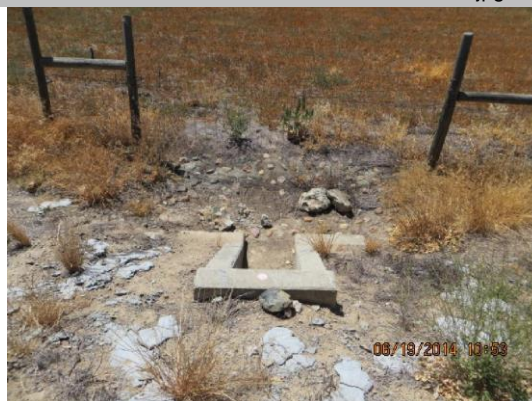
Photo 1 of 3 : UCIP_FA_2019_38997_71074.jpg

LM Start	1.22	Rating **	A/W	Issue No.	26
LM End	1.22	Issue Type +	Ma	Location *	
Category	Supplemental			GPS Latitude/Longitude	
				Start	End
Item	DRAFT DWR UCIP LMA Responsibility			38.094423 °	38.094423 °
				-121.154902 °	-121.154902 °
DWR ID	23845				
Comment Code					
Inspector Comment					
DS_ID:23845					
FS_ID:38997					
EP_NO: N/A					
Repair Type: No Action Needed					
Crossing Status: Found					
UCIP Comments:					
FIELD_STRUCT_DESC: 12-inch corrugated metal storm drainage pipe through the levee, 6.5 feet below the crown. Flap gate on the waterside (WS) end. Cobble grouted spillway. [Additional Reference(s): DWR Levee Log, 1987. USACE San Joaquin O&M Manual 612.2, 1967, (HLM 1.23) and 612 (addendum), February 1999, (HLM 1.23) (Station 64+78)].					
FS Date: 6/19/2014

Headwall at LS toe.

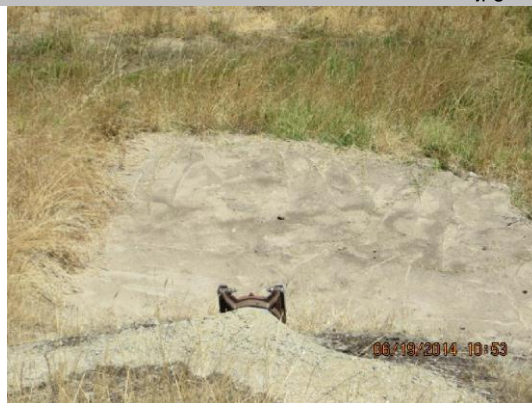
Photo 2 of 3 : UCIP_FA_2019_38997_71073.jpg

Pipe, flapgate, and grouted spillway on WS toe.

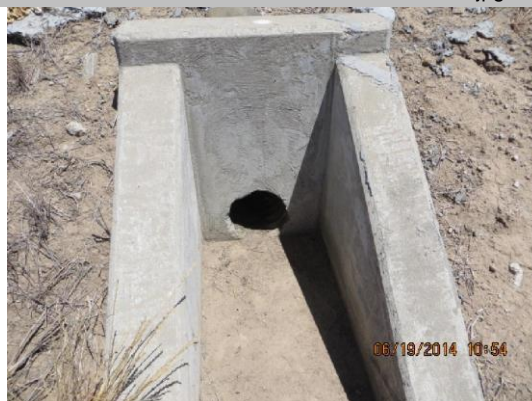
Photo 3 of 3 : UCIP_FA_2019_38997_71077.jpg

Headwall on LS toe.

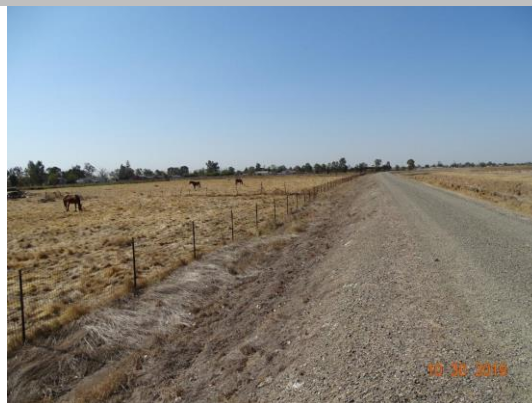
Photo 1 of 1 : FA_2019_NA0017_153_14_20191117_00036.jpg

LM Start	1.43	Rating **	A	Issue No.	14
LM End	1.43	Issue Type +	Ma	Location *	LS
Category	Earthen Levee			GPS Latitude/Longitude	
				Start	End
Item	Vegetation			38.094065 °	38.094065 °
				-121.151117 °	-121.151117 °
DWR ID	DWR_NA0017_09_f_2019_14				
Comment Code					
V1 : Control annual grass and weeds on the levee slopes and easements.					
Inspector Comment					
The annual vegetation in this section is well maintained, Fall 2019.

Typical view of vegetation on landside slope. Fall 2019

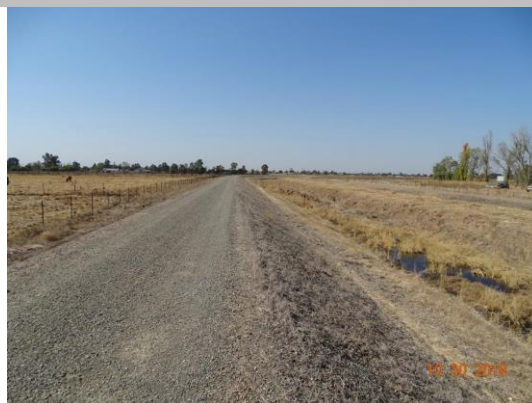
Photo 1 of 1 : FA_2019_NA0017_153_15_20191117_00037.jpg

LM Start	1.43	Rating **	A	Issue No.	15
LM End	1.43	Issue Type +	Ma	Location *	WS
Category	Earthen Levee			GPS Latitude/Longitude	
				Start	End
Item	Vegetation			38.094065 °	38.094065 °
				-121.151117 °	-121.151117 °
DWR ID	DWR_NA0017_09_f_2019_15				
Comment Code					
V1 : Control annual grass and weeds on the levee slopes and easements.					
Inspector Comment					
The annual vegetation in this section is well maintained, Fall 2019.

Typical view of vegetation on waterside slope. Fall 2019

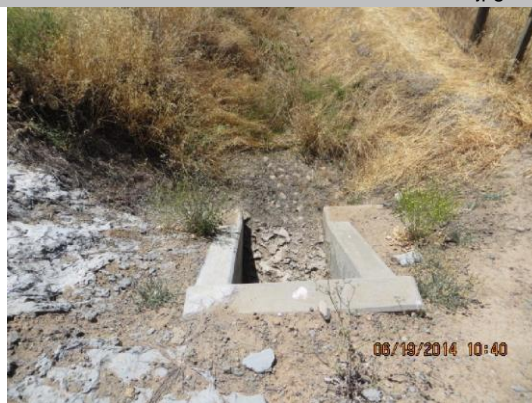
Photo 1 of 3 : UCIP_FA_2019_38977_71064.jpg

LM Start	1.44	Rating **	M	Issue No.	27
LM End	1.44	Issue Type +	Ma	Location *	
Category	Supplemental			GPS Latitude/Longitude	
				Start	End
Item	DRAFT DWR UCIP LMA Responsibility			38.094073 °	38.094073 °
				-121.150947 °	-121.150947 °
DWR ID	23847				
Comment Code					
Inspector Comment					
DS_ID:23847					
FS_ID:38977					
EP_NO: N/A					
Repair Type: Non-Urgent					
Crossing Status: Found					
UCIP Comments: Flapgate blocked by soil and possibly concrete on WS slope.					
FIELD_STRUCT_DESC: 21-inch corrugated metal drainage pipe through the levee, 5.5 feet below the crown. Flap gate on the waterside (WS) end. Cobble grouted spillway. [Additional Reference(s): DWR Levee Log, 1987. USACE San Joaquin O&M Manual 612.2, 1967, (HLM 1.45) and 612 (addendum), February 1999, (HLM 1.45) (Station 76+42)].					
FS Date: 6/19/2014

Concrete headwall on LS toe.
