**Flood Control Project Maintenance
Levee Inspections**

Maintenance Issue Types Only, Levee Inspection Report By Mile - Fall 2019

San Joaquin County Flood Control and Water Conservation District

Waterway	Bank	Unit Miles	Inspection Start/End	Inspector
Unit No. 01 Littlejohn Creek	Left	2.59	11/14/2019 11/14/2019	Alberto De Leon

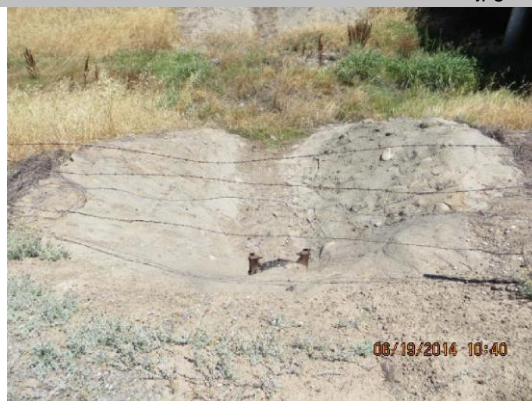
Photo 2 of 3 : UCIP_FA_2019_38977_71063.jpg

Pipe, flapgate, and grouted spillway on WS toe.

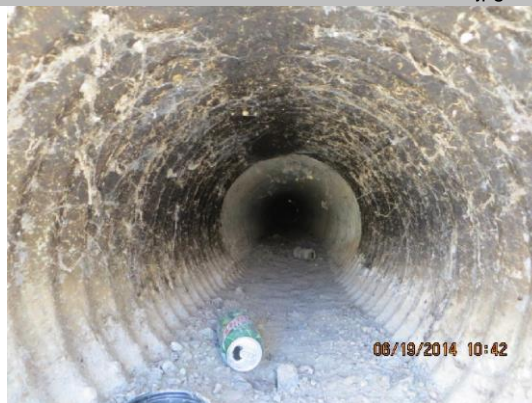
Photo 3 of 3 : UCIP_FA_2019_38977_71067.jpg

Inside pipe at LS toe.

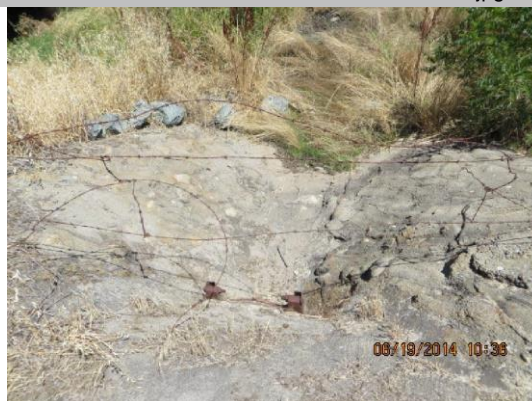
Photo 1 of 3 : UCIP_FA_2019_38963_71061.jpg

LM Start	1.45	Rating **	A/W	Issue No.	28	
LM End	1.45	Issue Type +	Ma	Location *		
Category	Supplemental			GPS Latitude/Longitude		
				Start	End	
Item	DRAFT DWR UCIP LMA Responsibility			38.094093 °	38.094093 °	
				-121.150703 °	-121.150703 °	
DWR ID	23848					
Comment Code						
Inspector Comment						
DS_ID:23848						
FS_ID:38963						
EP_NO: N/A						
Repair Type: No Action Needed						
Crossing Status: Found						
UCIP Comments:						
FIELD_STRUCT_DESC: 21-inch corrugated metal drainage pipe through the levee, 4 feet below the crown. Flap gate on the waterside (WS) end. Cobble grouted spillway. [Additional Reference(s): DWR Levee Log, 1987. USACE San Joaquin O&M Manual 612.2, 1967, (HLM 1.47)].						
FS Date: 6/19/2014

Pipe and flapgate on WS slope.

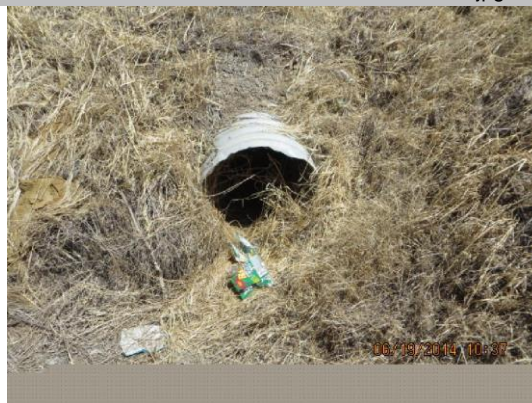
Photo 2 of 3 : UCIP_FA_2019_38963_70883.jpg

Pipe visible on LS toe.

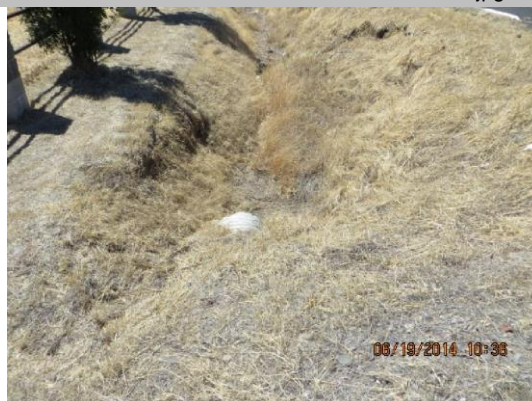
Photo 3 of 3 : UCIP_FA_2019_38963_71060.jpg

Pipe visible on LS toe.

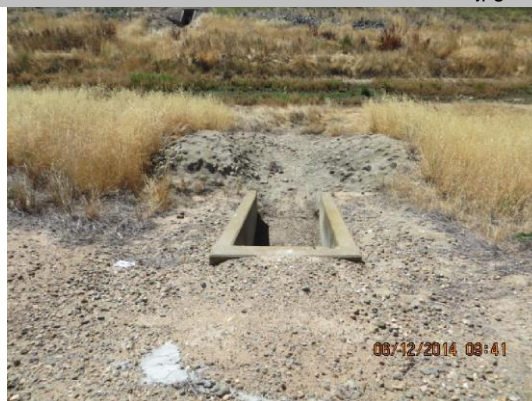
Photo 1 of 3 : UCIP_FA_2019_38567_70661.jpg

LM Start	0.03	Rating **	A/W	Issue No.	17	
LM End	0.03	Issue Type +	Ma	Location *		
Category	Supplemental			GPS Latitude/Longitude		
				Start		End
Item	DRAFT DWR UCIP LMA Responsibility			38.094170°		38.094170°
				-121.175555°		-121.175555°
DWR ID	23859					
Comment Code						
Inspector Comment						
DS_ID:23859						
FS_ID:38567						
EP_NO: N/A						
Repair Type: No Action Needed						
Crossing Status: Found						
UCIP Comments:						
FIELD_STRUCT_DESC: 36-inch corrugated metal drainage pipe through the levee, 7 feet below the crown. Concrete U-shaped headwall on both ends. Flap gate on the waterside (WS) end. Cobble grouted spillway. Cobble grouted intake on the landside (LS). [Additional Reference(s): DWR Levee Log, 1978. USACE San Joaquin O&M Manual 612.2, 1967, (HLM 0.03)].						
FS Date: 6/12/2014

Headwall, flapgate, and grouted spillway on WS slope.

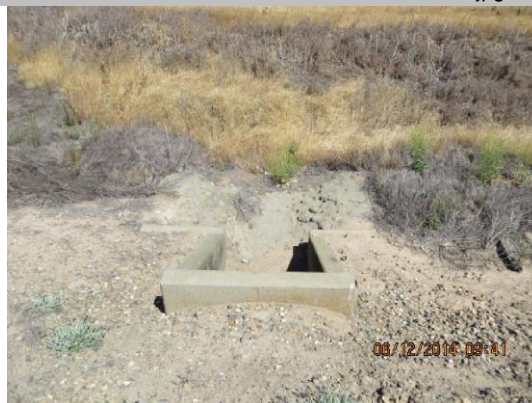
Photo 2 of 3 : UCIP_FA_2019_38567_70660.jpg

Headwall at LS toe.

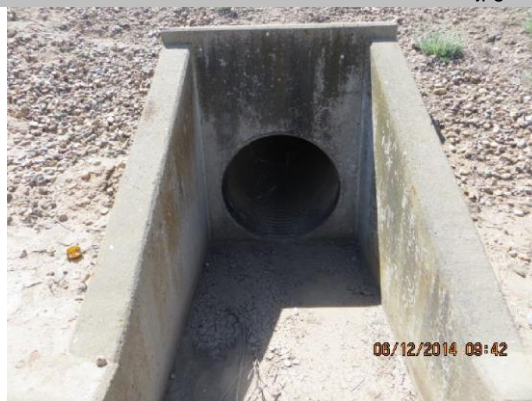
Photo 3 of 3 : UCIP_FA_2019_38567_70659.jpg

Headwall at LS toe.

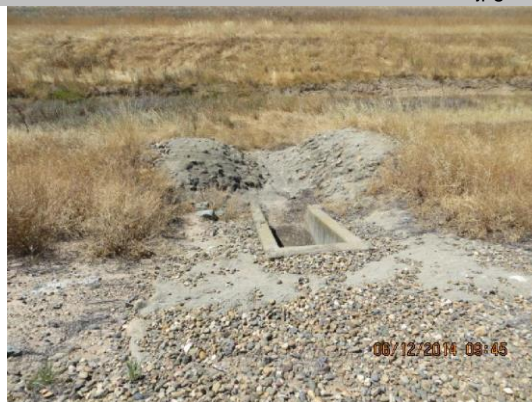
Photo 1 of 3 : UCIP_FA_2019_38568_70666.jpg

LM Start	0.24	Rating **	A/W	Issue No.	18	
LM End	0.24	Issue Type +	Ma	Location *		
Category	Supplemental			GPS Latitude/Longitude		
				Start		End
Item	DRAFT DWR UCIP LMA Responsibility			38.094879 °		38.094879 °
				-121.171734 °		-121.171734 °
DWR ID	23860					
Comment Code						
Inspector Comment						
DS_ID:23860 FS_ID:38568 EP_NO: N/A Repair Type: No Action Needed Crossing Status: Found UCIP Comments: FIELD_STRUCT_DESC: 24-inch corrugated metal drainage pipe through the levee, 7 feet below the crown. Concrete U-shaped headwall on both ends. Flap gate on the waterside (WS) end. Cobble grouted spillway. Cobble grouted intake on the landside (LS). [Additional Reference(s): DWR Levee Log, 1978. USACE San Joaquin O&M Manual 612.2, 1967, (HLM 0.24)]. FS Date: 6/12/2014

Headwall, flapgate, and grouted spillway on WS slope.

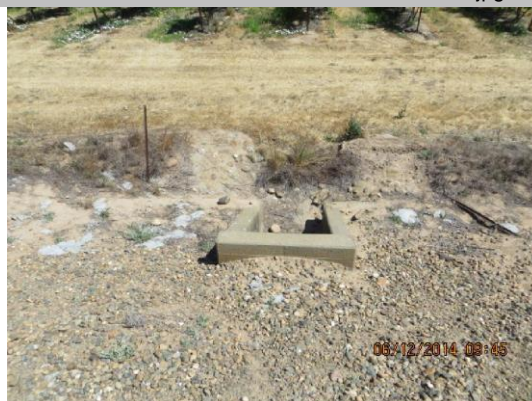
Photo 2 of 3 : UCIP_FA_2019_38568_70665.jpg

Headwall at LS toe.

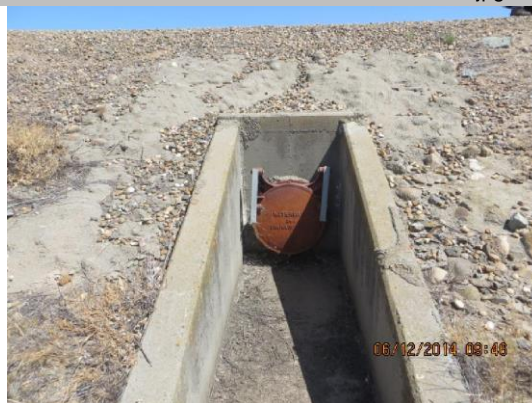
Photo 3 of 3 : UCIP_FA_2019_38568_70664.jpg

Headwall and flapgate on WS slope.

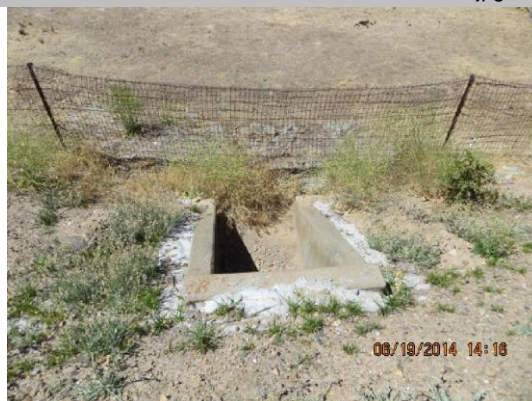
Photo 1 of 3 : UCIP_FA_2019_38994_71165.jpg

LM Start	0.36	Rating **	A/W	Issue No.	19
LM End	0.36	Issue Type +	Ma	Location *	
Category	Supplemental			GPS Latitude/Longitude	
				Start	End
Item	DRAFT DWR UCIP LMA Responsibility			38.095035°	38.095035°
				-121.168334°	-121.168334°
DWR ID	23861				
Comment Code					
Inspector Comment					
DS_ID:23861 FS_ID:38994 EP_NO: N/A Repair Type: No Action Needed Crossing Status: Found UCIP Comments: FIELD_STRUCT_DESC: 24-inch corrugated metal drainage pipe through the levee, 5 feet below the crown. Concrete U-shaped headwall on both ends. Flap gate on the waterside (WS) end. Cobble grouted spillway. Cobble grouted intake on the landside (LS). [Additional Reference(s): DWR Levee Log, 1978. USACE San Joaquin O&M Manual 612.2, 1967, (HLM 0.36)]. FS Date: 6/19/2014

Pipe and headwall on LS toe.

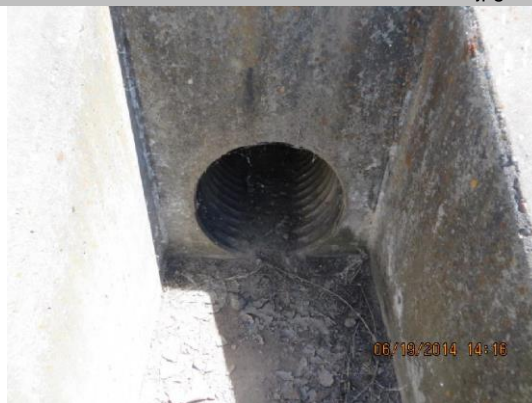
Photo 2 of 3 : UCIP_FA_2019_38994_71164.jpg

Pipe and headwall on LS toe.

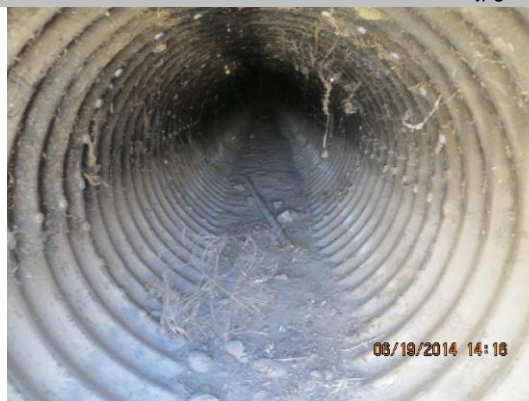
Photo 3 of 3 : UCIP_FA_2019_38994_71163.jpg

LM Start	0.36	Rating **	A/W	Issue No.	19 (cont)
LM End	0.36	Issue Type +	Ma	Location *	
Category	Supplemental			GPS Latitude/Longitude	
				Start	End
Item	DRAFT DWR UCIP LMA Responsibility			38.095035°	38.095035°
				-121.168334°	-121.168334°
DWR ID	23861				
Comment Code					
Inspector Comment					
DS_ID:23861 FS_ID:38994 EP_NO: N/A Repair Type: No Action Needed Crossing Status: Found UCIP Comments: FIELD_STRUCT_DESC: 24-inch corrugated metal drainage pipe through the levee, 5 feet below the crown. Concrete U-shaped headwall on both ends. Flap gate on the waterside (WS) end. Cobble grouted spillway. Cobble grouted intake on the landside (LS). [Additional Reference(s): DWR Levee Log, 1978. USACE San Joaquin O&M Manual 612.2, 1967, (HLM 0.36)]. FS Date: 6/19/2014

Inside pipe at LS toe.

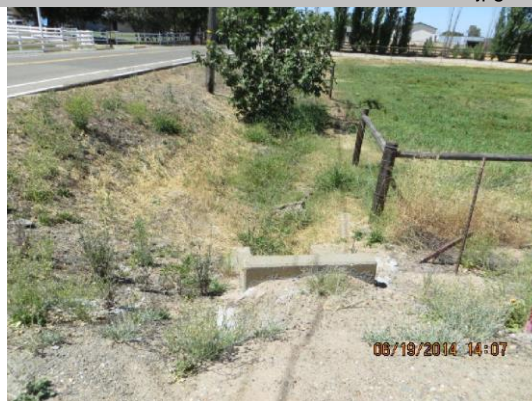
Photo 1 of 3 : UCIP_FA_2019_38992_71158.jpg

LM Start	0.45	Rating **	A/W	Issue No.	20
LM End	0.45	Issue Type +	Ma	Location *	
Category	Supplemental			GPS Latitude/Longitude	
				Start	End
Item	DRAFT DWR UCIP LMA Responsibility			38.095271 °	38.095271 °
				-121.166654 °	-121.166654 °
DWR ID	23863				
Comment Code					
Inspector Comment					
DS_ID:23863 FS_ID:38992 EP_NO: N/A Repair Type: No Action Needed Crossing Status: Found UCIP Comments: FIELD_STRUCT_DESC: 24-inch corrugated metal drainage pipe through the levee, 4 feet below the crown. Concrete U-shaped headwall on both ends. Flap gate on the waterside (WS) end. Cobble grouted spillway. Cobble grouted intake on the landside (LS). [Additional Reference(s): DWR Levee Log, 1978. USACE San Joaquin O&M Manual 612.2, 1967, (HLM 0.46)]. FS Date: 6/19/2014

Pipe and headwall on LS toe.

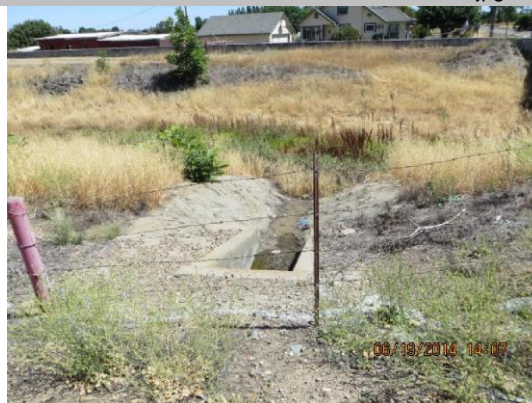
Photo 2 of 3 : UCIP_FA_2019_38992_71157.jpg

Pipe, headwall, flapgate, and grouted spillway on WS toe.

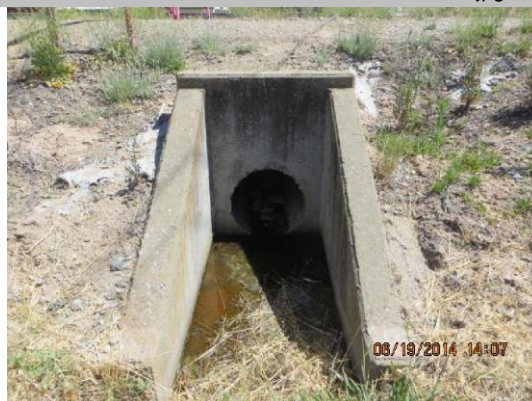
Photo 3 of 3 : UCIP_FA_2019_38992_71156.jpg

LM Start	0.45	Rating **	A/W	Issue No.	20 (cont)
LM End	0.45	Issue Type +	Ma	Location *	
Category	Supplemental			GPS Latitude/Longitude	
				Start	End
Item	DRAFT DWR UCIP LMA Responsibility			38.095271 °	38.095271 °
				-121.166654 °	-121.166654 °
DWR ID	23863				
Comment Code					
Inspector Comment					
DS_ID:23863 FS_ID:38992 EP_NO: N/A Repair Type: No Action Needed Crossing Status: Found UCIP Comments: FIELD_STRUCT_DESC: 24-inch corrugated metal drainage pipe through the levee, 4 feet below the crown. Concrete U-shaped headwall on both ends. Flap gate on the waterside (WS) end. Cobble grouted spillway. Cobble grouted intake on the landside (LS). [Additional Reference(s): DWR Levee Log, 1978. USACE San Joaquin O&M Manual 612.2, 1967, (HLM 0.46)]. FS Date: 6/19/2014

Pipe and headwall on LS toe.

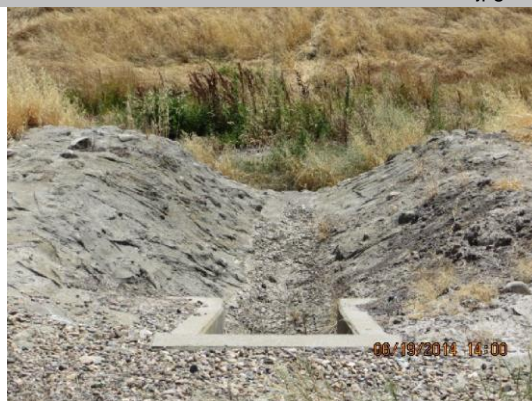
Photo 1 of 3 : UCIP_FA_2019_38990_71153.jpg

Comment Code						
Inspector Comment						
DS_ID:23864 FS_ID:38990 EP_NO: N/A Repair Type: No Action Needed Crossing Status: Found UCIP Comments: FIELD_STRUCT_DESC: 24-inch corrugated metal drainage pipe through the levee, 5 feet below the crown. Concrete U-shaped headwall on both ends. Flap gate on the waterside (WS) end. Cobble grouted spillway. Cobble grouted intake on the landside (LS). (Temporary 3-inch polyvinyl chloride drainage pipe sleeved through drainage pipe with portable LS pump under Permit No. 11617, 1976 - Tom Patterson). [Additional Reference(s): DWR Levee Log, 1978. USACE San Joaquin O&M Manual 612.2, 1967, (HLM 0.58)]. FS Date: 6/19/2014

Pipe, headwall, flapgate, and grouted spillway on WS toe.

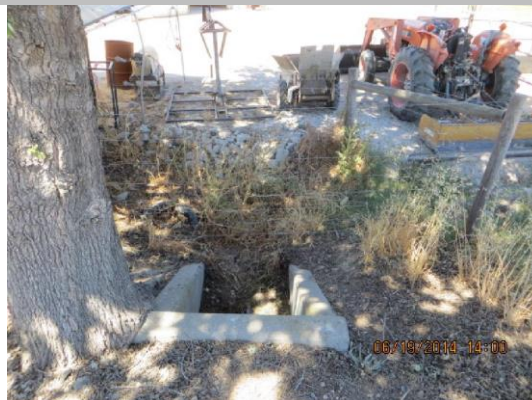
Photo 2 of 3 : UCIP_FA_2019_38990_71152.jpg

Pipe and headwall on LS toe.

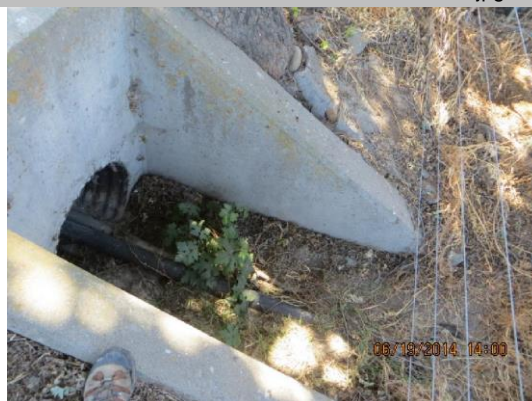
Photo 3 of 3 : UCIP_FA_2019_38990_71151.jpg

Comment Code						
Inspector Comment						
DS_ID:23864 FS_ID:38990 EP_NO: N/A Repair Type: No Action Needed Crossing Status: Found UCIP Comments: FIELD_STRUCT_DESC: 24-inch corrugated metal drainage pipe through the levee, 5 feet below the crown. Concrete U-shaped headwall on both ends. Flap gate on the waterside (WS) end. Cobble grouted spillway. Cobble grouted intake on the landside (LS). (Temporary 3-inch polyvinyl chloride drainage pipe sleeved through drainage pipe with portable LS pump under Permit No. 11617, 1976 - Tom Patterson). [Additional Reference(s): DWR Levee Log, 1978. USACE San Joaquin O&M Manual 612.2, 1967, (HLM 0.58)]. FS Date: 6/19/2014

Pipe and headwall on LS toe.

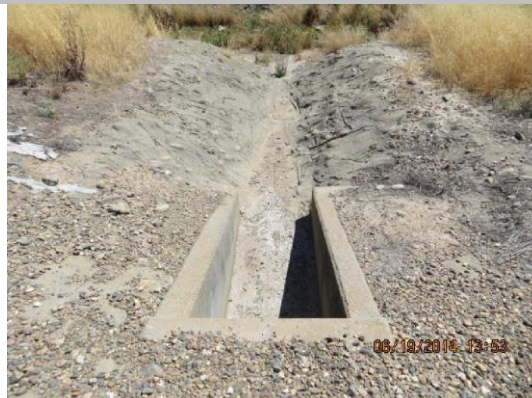
Photo 1 of 3 : UCIP_FA_2019_38989_71148.jpg

LM Start	0.86	Rating **	A/W	Issue No.	22	
LM End	0.86	Issue Type +	Ma	Location *		
Category	Supplemental			GPS Latitude/Longitude		
				Start	End	
Item	DRAFT DWR UCIP LMA Responsibility			38.094639 °	38.094639 °	
				-121.159426 °	-121.159426 °	
DWR ID	23865					
Comment Code						
Inspector Comment						
DS_ID:23865						
FS_ID:38989						
EP_NO: N/A						
Repair Type: No Action Needed						
Crossing Status: Found						
UCIP Comments:						
FIELD_STRUCT_DESC: 24-inch corrugated metal drainage pipe through the levee, 5.5 feet below the crown. Concrete U-shaped headwall on both ends. Flap gate on the waterside (WS) end. Cobble grouted spillway. Cobble grouted intake on the landside (LS). [Additional Reference(s): DWR Levee Log, 1978. USACE San Joaquin O&M Manual 612.2, 1967, (HLM 0.86)].						
FS Date: 6/19/2014

Pipe, headwall, flapgate, and grouted spillway on WS toe.

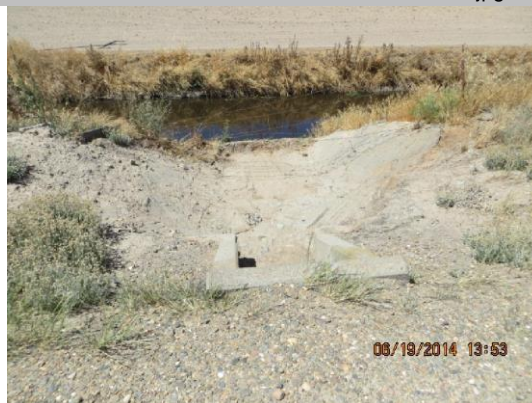
Photo 2 of 3 : UCIP_FA_2019_38989_71147.jpg

Pipe and headwall on LS toe.

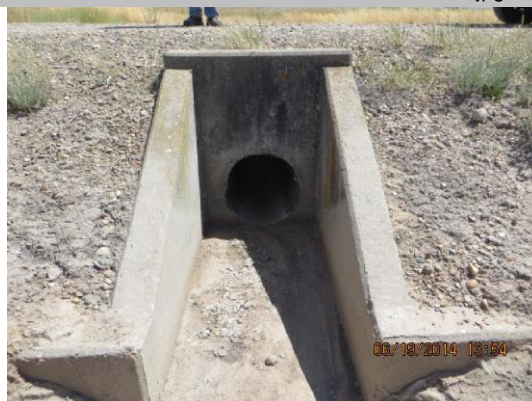
Photo 3 of 3 : UCIP_FA_2019_38989_71146.jpg

LM Start	0.86	Rating **	A/W	Issue No.	22 (cont)	
LM End	0.86	Issue Type +	Ma	Location *		
Category	Supplemental			GPS Latitude/Longitude		
				Start	End	
Item	DRAFT DWR UCIP LMA Responsibility			38.094639 °	38.094639 °	
				-121.159426 °	-121.159426 °	
DWR ID	23865					
Comment Code						
Inspector Comment						
DS_ID:23865 FS_ID:38989 EP_NO: N/A Repair Type: No Action Needed Crossing Status: Found UCIP Comments: FIELD_STRUCT_DESC: 24-inch corrugated metal drainage pipe through the levee, 5.5 feet below the crown. Concrete U-shaped headwall on both ends. Flap gate on the waterside (WS) end. Cobble grouted spillway. Cobble grouted intake on the landside (LS). [Additional Reference(s): DWR Levee Log, 1978. USACE San Joaquin O&M Manual 612.2, 1967, (HLM 0.86)]. FS Date: 6/19/2014

Pipe and headwall on LS toe.

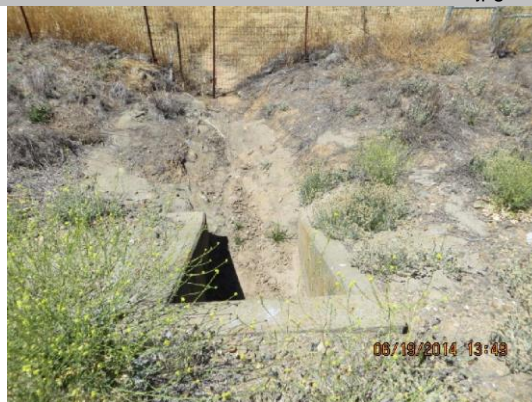
Photo 1 of 3 : UCIP_FA_2019_38988_71144.jpg

LM Start	1.08	Rating **	A/W	Issue No.	23	
LM End	1.08	Issue Type +	Ma	Location *		
Category	Supplemental			GPS Latitude/Longitude		
				Start		End
Item	DRAFT DWR UCIP LMA Responsibility			38.094699 °		38.094699 °
				-121.155329 °		-121.155329 °
DWR ID	23866					
Comment Code						
Inspector Comment						
DS_ID:23866						
FS_ID:38988						
EP_NO: N/A						
Repair Type: No Action Needed						
Crossing Status: Found						
UCIP Comments:						
FIELD_STRUCT_DESC: 24-inch corrugated metal drainage pipe						
on both ends. Flap gate on the crown. Concrete U-shaped headwall						
on both ends. Flap gate on the waterside (WS) end. Cobble grouted						
spillway. Cobble grouted intake on the landside (LS). [Additional						
Reference(s): DWR Levee Log, 1978. USACE San Joaquin O&M						
Manual 612.2, 1967, (HLM 1.09)].						
FS Date: 6/19/2014

Pipe and headwall on LS toe.

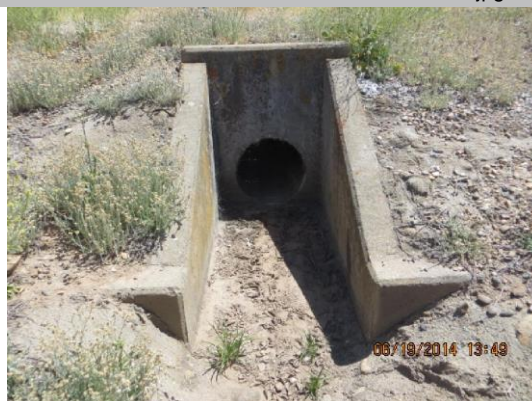
Photo 2 of 3 : UCIP_FA_2019_38988_71143.jpg

LM Start	1.08	Rating **	A/W	Issue No.	23 (cont)
LM End	1.08	Issue Type +	Ma	Location *	
Category	Supplemental			GPS Latitude/Longitude	
				Start	End
Item	DRAFT DWR UCIP LMA Responsibility			38.094699 °	38.094699 °
				-121.155329 °	-121.155329 °
DWR ID	23866				
Comment Code					
Inspector Comment					
DS_ID:23866 FS_ID:38988 EP_NO: N/A Repair Type: No Action Needed Crossing Status: Found UCIP Comments: FIELD_STRUCT_DESC: 24-inch corrugated metal drainage pipe through the levee, 5 feet below the crown. Concrete U-shaped headwall on both ends. Flap gate on the waterside (WS) end. Cobble grouted spillway. Cobble grouted intake on the landside (LS). [Additional Reference(s): DWR Levee Log, 1978. USACE San Joaquin O&M Manual 612.2, 1967, (HLM 1.09)]. FS Date: 6/19/2014

Pipe and headwall on LS toe.

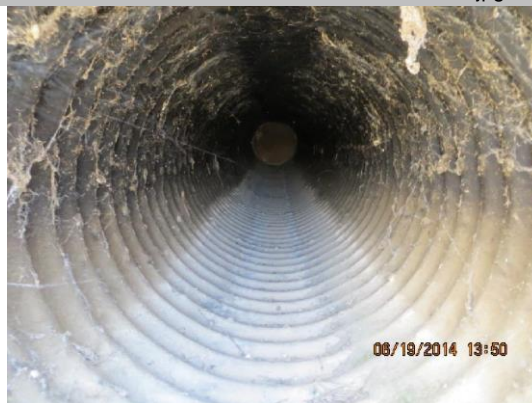
Photo 3 of 3 : UCIP_FA_2019_38988_71142.jpg

Inside pipe at LS toe.

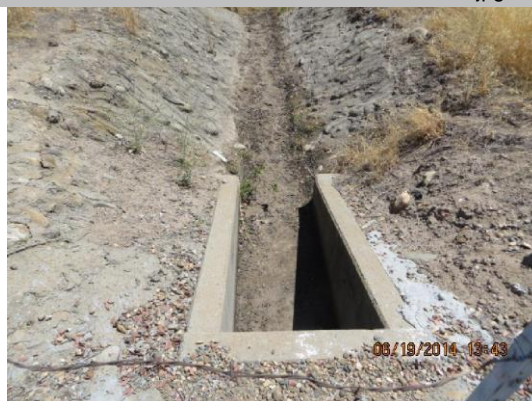
Photo 1 of 3 : UCIP_FA_2019_38987_71139.jpg

LM Start	1.32	Rating **	A/W	Issue No.	24
LM End	1.32	Issue Type +	Ma	Location *	
Category	Supplemental			GPS Latitude/Longitude	
				Start	End
Item	DRAFT DWR UCIP LMA Responsibility			38.094351 °	38.094351 °
				-121.150962 °	-121.150962 °
DWR ID	23867				
Comment Code					
Inspector Comment					
DS_ID:23867					
FS_ID:38987					
EP_NO: N/A					
Repair Type: No Action Needed					
Crossing Status: Found					
UCIP Comments:					
FIELD_STRUCT_DESC: 24-inch corrugated metal drainage pipe through the levee, 4 feet below the crown. Concrete U-shaped headwall on both ends. Flap gate on the waterside (WS) end. Cobble grouted spillway. Cobble grouted intake on the landside (LS). [Additional Reference(s): DWR Levee Log, 1978. USACE San Joaquin O&M Manual 612.2, 1967, (HLM 1.33)].					
FS Date: 6/19/2014

Pipe, headwall, flapgate, and grouted spillway on WS toe.

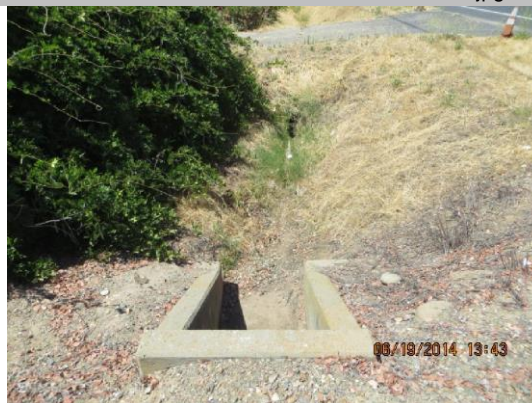
Photo 2 of 3 : UCIP_FA_2019_38987_71138.jpg

Pipe and headwall on LS toe.

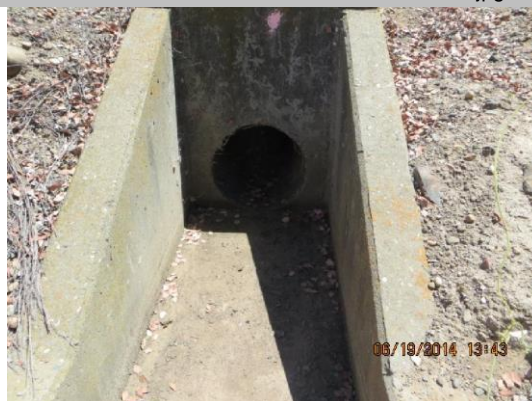
Photo 3 of 3 : UCIP_FA_2019_38987_71137.jpg

LM Start	1.32	Rating **	A/W	Issue No.	24 (cont)	
LM End	1.32	Issue Type +	Ma	Location *		
Category	Supplemental			GPS Latitude/Longitude		
				Start		End
Item	DRAFT DWR UCIP LMA Responsibility			38.094351 °		38.094351 °
				-121.150962 °		-121.150962 °
DWR ID	23867					
Comment Code						
Inspector Comment						
DS_ID:23867						
FS_ID:38987						
EP_NO: N/A						
Repair Type: No Action Needed						
Crossing Status: Found						
UCIP Comments:						
FIELD_STRUCT_DESC: 24-inch corrugated metal drainage pipe through the levee, 4 feet below the crown. Concrete U-shaped headwall on both ends. Flap gate on the waterside (WS) end. Cobble grouted spillway. Cobble grouted intake on the landside (LS). [Additional Reference(s): DWR Levee Log, 1978. USACE San Joaquin O&M Manual 612.2, 1967, (HLM 1.33)].						
FS Date: 6/19/2014

Pipe and headwall on LS toe.

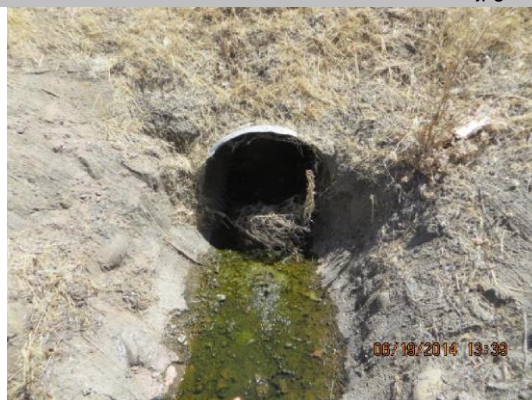
Photo 3 of 3 : UCIP_FA_2019_51721_71132.jpg

Pipe on LS toe.

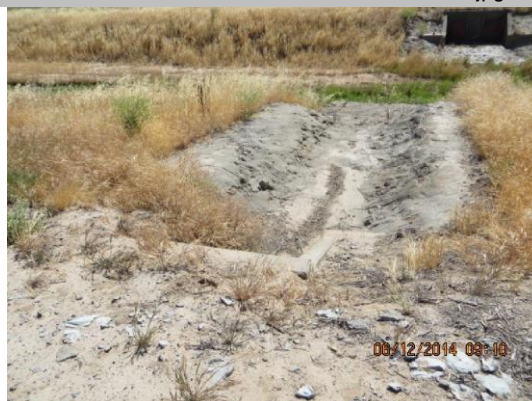
Photo 1 of 3 : UCIP_FA_2019_38566_70656.jpg

LM Start	0.16	Rating **	A/W	Issue No.	207
LM End	0.16	Issue Type +	Ma	Location *	
Category	Supplemental			GPS Latitude/Longitude	
				Start	End
Item	DRAFT DWR UCIP LMA Responsibility			38.097164°	38.097164°
				-121.169289°	-121.169289°
DWR ID	23880				
Comment Code					
Inspector Comment					
DS_ID:23880					
FS_ID:38566					
EP_NO: N/A					
Repair Type: No Action Needed					
Crossing Status: Found					
UCIP Comments:					
FIELD_STRUCT_DESC: 24-inch corrugated metal drainage pipe through the levee, 5 feet below the crown. Concrete U-shaped headwall on both ends. Flap gate on the waterside (WS) end. Cobble grouted spillway. Cobble grouted intake on the landside (LS). [Additional Reference(s): DWR Levee Log, 1978. USACE San Joaquin O&M Manual 612.2, 1967, (HLM 0.16)].					
FS Date: 6/11/2014

Headwall, flapgate, and grouted spillway on WS slope.

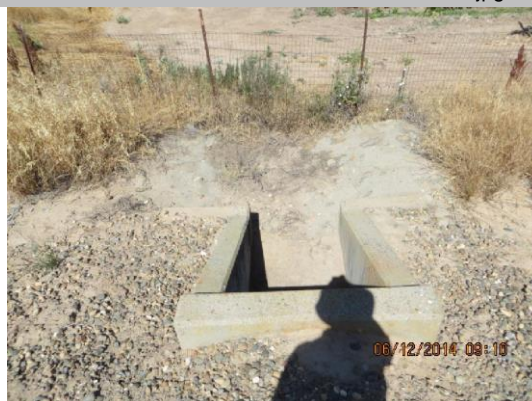
Photo 2 of 3 : UCIP_FA_2019_38566_70655.jpg

LM Start	0.16	Rating **	A/W	Issue No.	207 (cont)	
LM End	0.16	Issue Type +	Ma	Location *		
Category	Supplemental			GPS Latitude/Longitude		
				Start	End	
Item	DRAFT DWR UCIP LMA Responsibility			38.097164 °	38.097164 °	
				-121.169289 °	-121.169289 °	
DWR ID	23880					
Comment Code						
Inspector Comment						
DS_ID:23880 FS_ID:38566 EP_NO: N/A Repair Type: No Action Needed Crossing Status: Found UCIP Comments: FIELD_STRUCT_DESC: 24-inch corrugated metal drainage pipe through the levee, 5 feet below the crown. Concrete U-shaped headwall on both ends. Flap gate on the waterside (WS) end. Cobble grouted spillway. Cobble grouted intake on the landside (LS). [Additional Reference(s): DWR Levee Log, 1978. USACE San Joaquin O&M Manual 612.2, 1967, (HLM 0.16)]. FS Date: 6/11/2014

Headwall at LS toe.

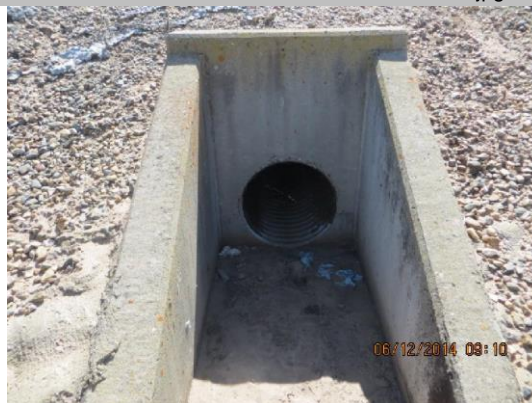
Photo 3 of 3 : UCIP_FA_2019_38566_70654.jpg

Headwall at LS toe.

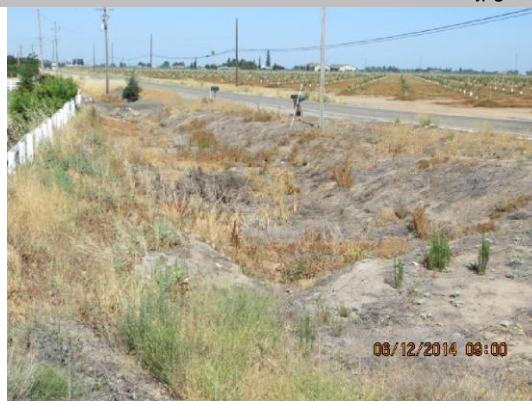
Photo 1 of 3 : UCIP_FA_2019_38564_70647.jpg

LM Start	0.47	Rating **	M	Issue No.	208	
LM End	0.47	Issue Type +	Ma	Location *		
Category	Supplemental			GPS Latitude/Longitude		
				Start	End	
Item	DRAFT DWR UCIP LMA Responsibility			38.101560 °	38.101560 °	
				-121.168634 °	-121.168634 °	
DWR ID	23881					
Comment Code						
Inspector Comment						
DS_ID:23881 FS_ID:38564 EP_NO: N/A Repair Type: Non-Urgent Crossing Status: Found UCIP Comments: Slidegate does not function properly up or down. FIELD_STRUCT_DESC: 24-inch corrugated metal drainage pipe through the levee, 11 feet below the crown. Slide gate in 36-inch corrugated metal riser unit on the waterside (WS). Concrete U-shaped headwall on the WS end. Cobble grouted spillway. Cobble grouted intake on the landside (LS). [Additional Reference(s): DWR Levee Log, 1978. USACE San Joaquin O&M Manual 612.2, 1967, (HLM 0.47)]. FS Date: 6/12/2014

Headwall at LS toe.

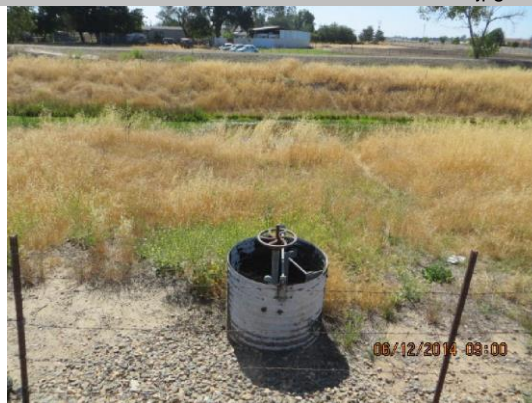
Photo 2 of 3 : UCIP_FA_2019_38564_70646.jpg

Slide gate in 36-inch CMP riser on WS slope. slide gate does not function as handle is detached from mechanism.

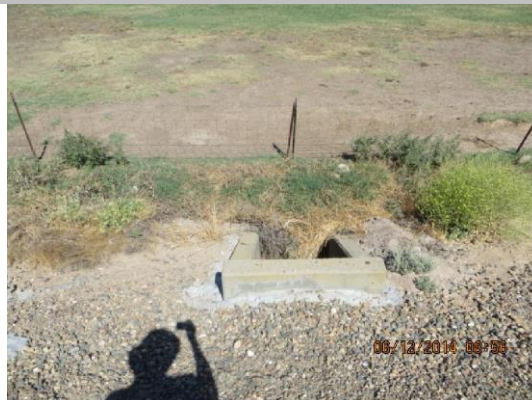
Photo 1 of 3 : UCIP_FA_2019_38565_70651.jpg

Headwall at LS toe.

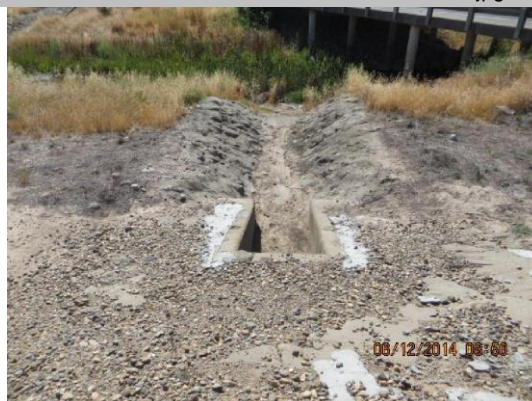
Photo 2 of 3 : UCIP_FA_2019_38565_70650.jpg

Headwall, flapgate, and grouted spillway on WS slope.

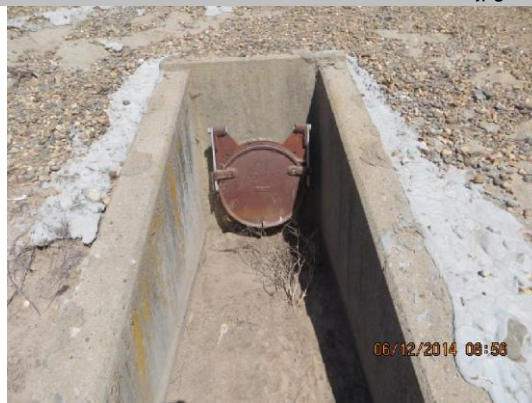
Photo 3 of 3 : UCIP_FA_2019_38565_70649.jpg

Headwall and flapgate on WS slope.

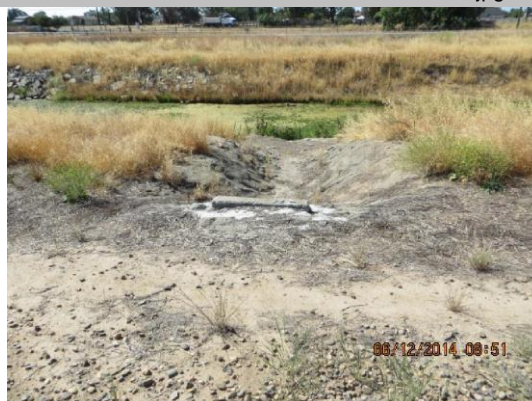
Photo 1 of 3 : UCIP_FA_2019_38561_70630.jpg

Comment Code						
Inspector Comment						
DS_ID:23883						
FS_ID:38561						
EP_NO: N/A						
Repair Type: Non-Urgent						
Crossing Status: Found						
UCIP Comments: Pipe filled in with soil on the LS toe and appears to be temporarily abandoned.						
FIELD_STRUCT_DESC: 24-inch corrugated metal drainage pipe through the levee, 6.5 feet below the crown. Concrete U-shaped headwall on both ends. Flap gate on the waterside (WS) end. Cobble grouted spillway. Cobble grouted intake on the landside (LS).						
[Additional Reference(s): DWR Levee Log, 1978. USACE San Joaquin O&M Manual 612.2, 1967, (HLM 0.55)].						
FS Date: 6/12/2014

Headwall, flapgate, and grouted spillway on WS slope.

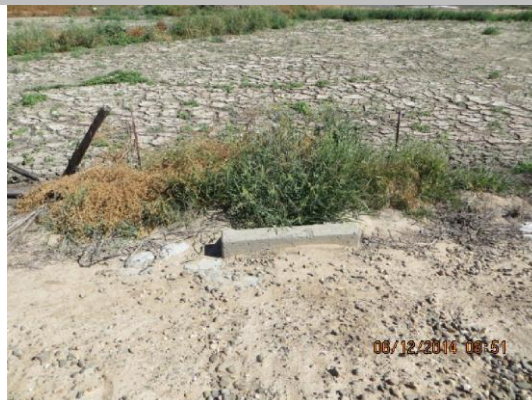
Photo 2 of 3 : UCIP_FA_2019_38561_70629.jpg

Headwall at LS toe has been filled in with soil.

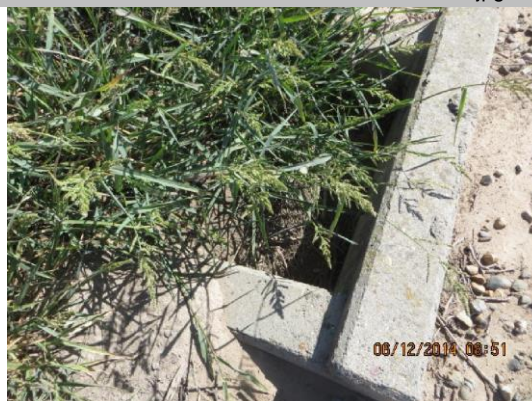
Photo 3 of 3 : UCIP_FA_2019_38561_70628.jpg

Comment Code						
Inspector Comment						
DS_ID:23883						
FS_ID:38561						
EP_NO: N/A						
Repair Type: Non-Urgent						
Crossing Status: Found						
UCIP Comments: Pipe filled in with soil on the LS toe and appears to be temporarily abandoned.						
FIELD_STRUCT_DESC: 24-inch corrugated metal drainage pipe through the levee, 6.5 feet below the crown. Concrete U-shaped headwall on both ends. Flap gate on the waterside (WS) end. Cobble grouted spillway. Cobble grouted intake on the landside (LS).						
[Additional Reference(s): DWR Levee Log, 1978. USACE San Joaquin O&M Manual 612.2, 1967, (HLM 0.55)].						
FS Date: 6/12/2014

Headwall at LS toe has been filled in with soil.

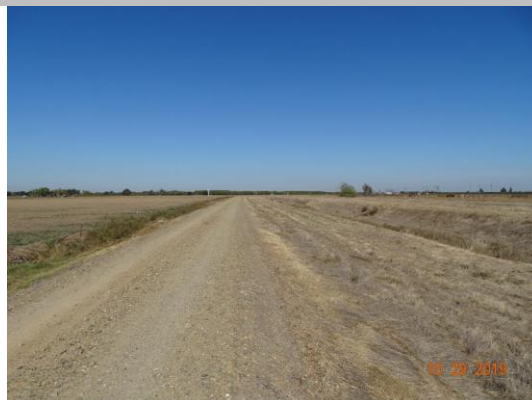
Photo 1 of 1 : FA_2019_NA0017_155_40_20191117_00097.jpg

LM Start	0.84	Rating **	A	Issue No.	40
LM End	0.84	Issue Type +	Ma	Location *	WS
Category	Earthen Levee			GPS Latitude/Longitude	
				Start	End
Item	Vegetation			38.105961 °	38.105961 °
				-121.166270 °	-121.166270 °
DWR ID	DWR_NA0017_11_f_2019_40				
Comment Code					
V1 : Control annual grass and weeds on the levee slopes and easements.					
Inspector Comment					
The annual vegetation in this section is well maintained, Fall 2019.

Typical view of vegetation on waterside slope. Fall 2019

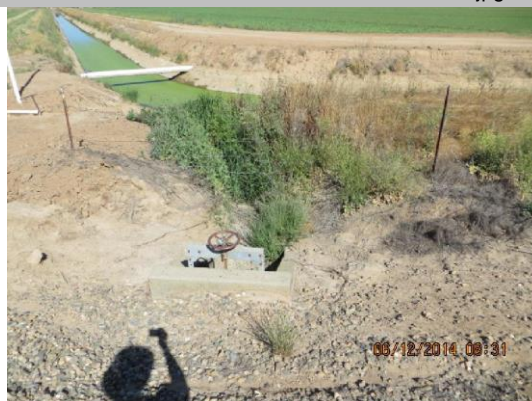
Photo 1 of 3 : UCIP_FA_2019_38559_70621.jpg

Headwall and slidegate on LS toe.

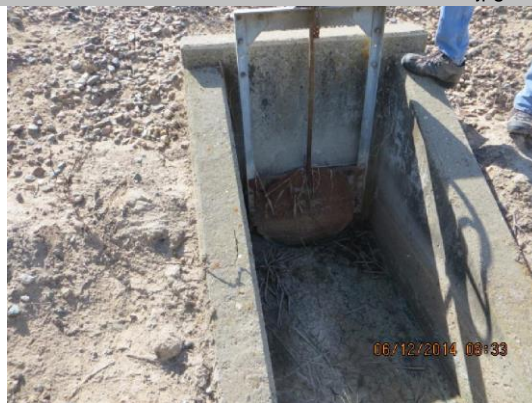
Photo 2 of 3 : UCIP_FA_2019_38559_70620.jpg

Headwall and slidegate on LS toe.

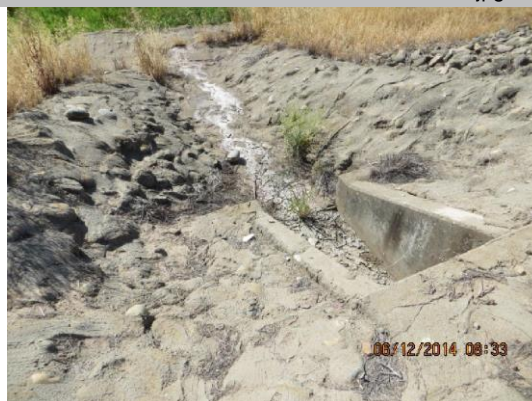
Photo 3 of 3 : UCIP_FA_2019_38559_70623.jpg

Headwall, flapgate, and grouted spillway on WS slope.

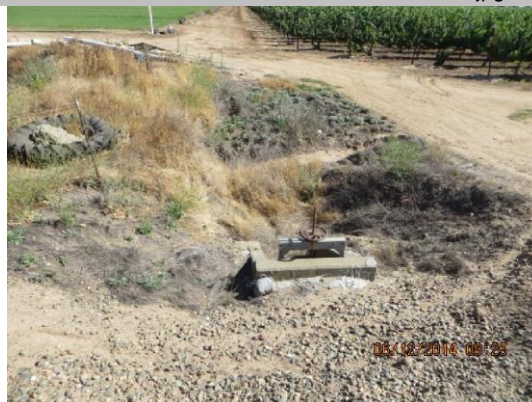
Photo 1 of 3 : UCIP_FA_2019_38558_70618.jpg

Headwall and slidegate on LS toe.

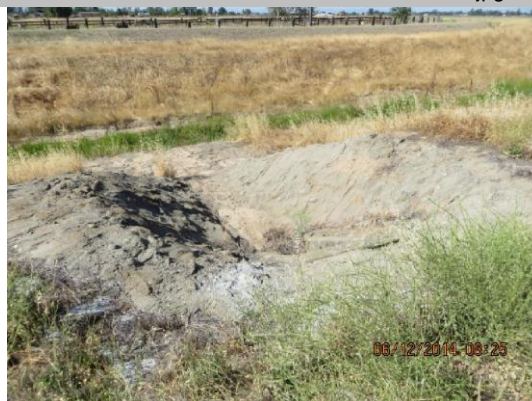
Photo 2 of 3 : UCIP_FA_2019_38558_70617.jpg

Headwall, flapgate, and grouted spillway on WS slope.

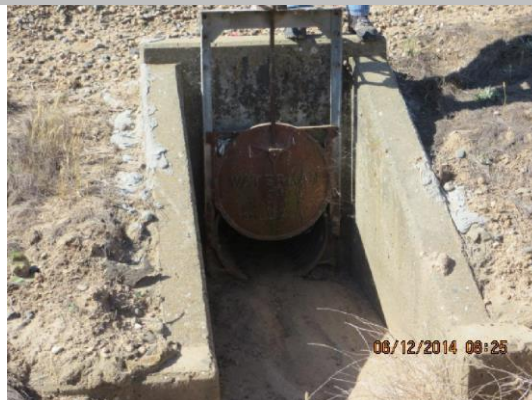
Photo 3 of 3 : UCIP_FA_2019_38558_70616.jpg

Headwall and slidegate on LS toe.

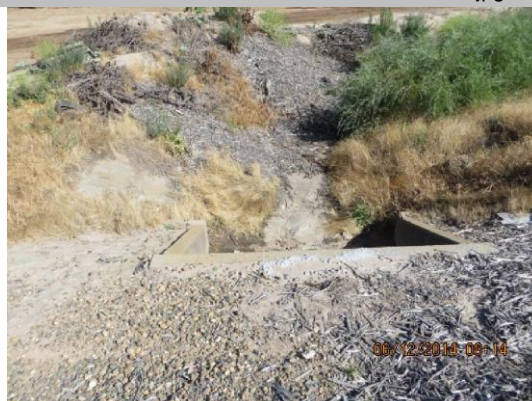
Photo 1 of 3 : UCIP_FA_2019_38557_70613.jpg

Comment Code						
Inspector Comment						
DS_ID:23871 FS_ID:38557 EP_NO: N/A Repair Type: Non-Urgent Crossing Status: Found UCIP Comments: Slidegate may be rusted shut or does not function. Heavy sediment buildup in pipe. Lid on CMP riser needs repair. FIELD_STRUCT_DESC: 1 of 2: 36-inch corrugated metal drainage pipe through the levee, 7 feet below the crown. Slide gate in 48-inch corrugated metal riser unit on the waterside (WS) slope. Concrete U-shaped headwall on both ends. Flap gate on the WS end. Cobble grouted spillway. Cobble grouted intake on the landside (LS). [Additional Reference(s): DWR Levee Log, 1978. USACE San Joaquin O&M Manual 612.2, 1967, (HLM 1.51)]. FS Date: 6/12/2014

Headwall at LS toe.

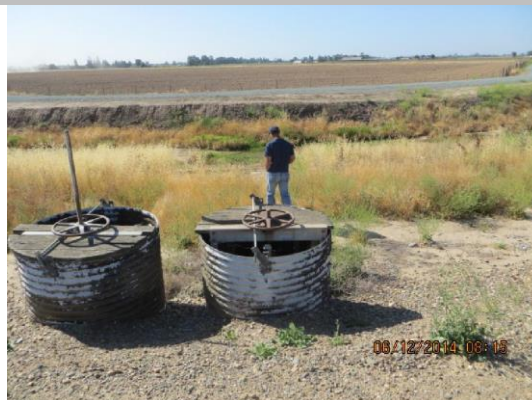
Photo 2 of 3 : UCIP_FA_2019_38557_70612.jpg

Slidegate inside CMP riser on WS shoulder. Lid needs repair.

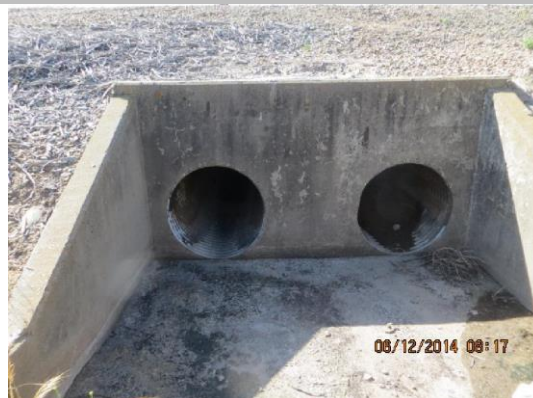
Photo 3 of 3 : UCIP_FA_2019_38557_70611.jpg

Comment Code						
Inspector Comment						
DS_ID:23871						
FS_ID:38557						
EP_NO: N/A						
Repair Type: Non-Urgent						
Crossing Status: Found						
UCIP Comments: Slidegate may be rusted shut or does not function.						
Heavy sediment buildup in pipe. Lid on CMP riser needs repair.						
FIELD_STRUCT_DESC: 1 of 2: 36-inch corrugated metal drainage pipe						
through the levee, 7 feet below the crown. Slide gate in 48-inch						
corrugated metal riser unit on the waterside (WS) slope. Concrete U-						
shaped headwall on both ends. Flap gate on the WS end. Cobble						
grouted spillway. Cobble grouted intake on the landside (LS).						
[Additional Reference(s): DWR Levee Log, 1978. USACE San Joaquin						
O&M Manual 612.2, 1967, (HLM 1.51)].						
FS Date: 6/12/2014

Headwall at LS toe.

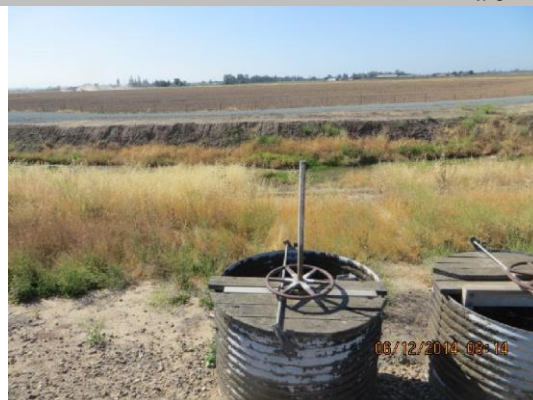
Photo 1 of 3 : UCIP_FA_2019_38556_70608.jpg

Comment Code						
Inspector Comment						
DS_ID:23897						
FS_ID:38556						
EP_NO: N/A						
Repair Type: Non-Urgent						
Crossing Status: Found						
UCIP Comments: Slidegate not functional or rusted in place. No lid on						
CMP riser at WS slope.						
FIELD_STRUCT_DESC: 2 of 2: 36-inch corrugated metal drainage pipe						
through the levee, 7 feet below the crown. Slide gate in 48-inch						
corrugated metal riser unit on the waterside (WS) slope. Concrete U-						
shaped headwall on both ends. Flap gate on the WS end. Cobble						
grouted spillway. Cobble grouted intake on the landside (LS).						
[Additional Reference(s): DWR Levee Log, 1978. USACE San Joaquin						
O&M Manual 612.2, 1967, (HLM 1.51)].						
FS Date: 6/12/2014

Slidegate in CMP riser on WS shoulder. No lid and gate valve does not work.

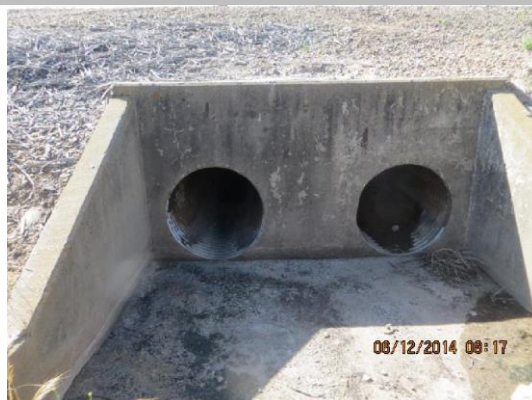
Photo 3 of 3 : UCIP_FA_2019_38556_70606.jpg

Headwall at LS toe.

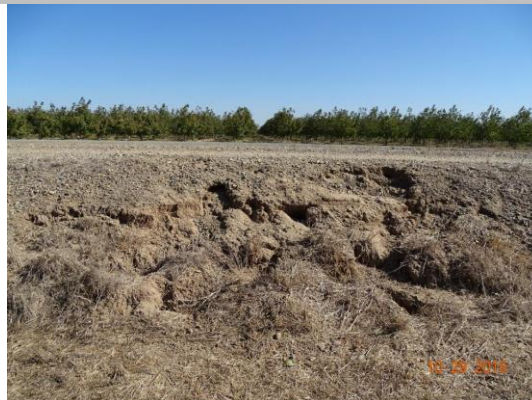
Photo 1 of 1 : FA_2019_NA0017_155_42_20191117_00098.jpg

LM Start	1.58	Rating **	U	Issue No.	42
LM End	1.60	Issue Type +	Ma	Location *	LS
Category	Earthen Levee			GPS Latitude/Longitude	
				Start	End
Item	Animal Control			38.112401°	38.112702°
				-121.158875°	-121.158873°
DWR ID	DWR_NA0017_11_f_2019_42				
Comment Code					
A3 : No rodents visible, but rodent burrows visible; need to backfill and compact or grout burrows.					
Inspector Comment

View of multiple animal burrows on landside slope. Fall 2019

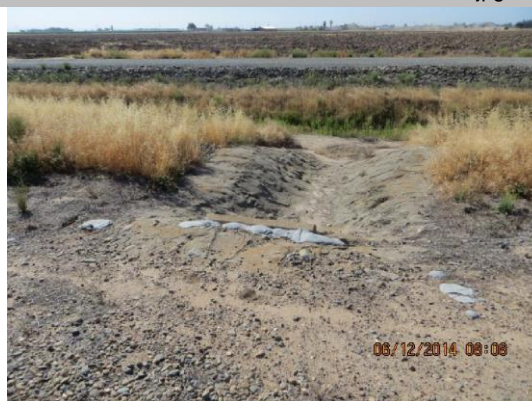
Photo 1 of 3 : UCIP_FA_2019_38555_70603.jpg

Headwall, flapgate, and grouted spillway on WS slope.

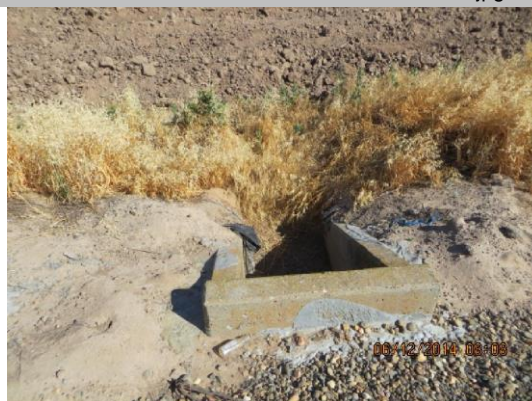
Photo 2 of 3 : UCIP_FA_2019_38555_70602.jpg

Headwall at LS toe.

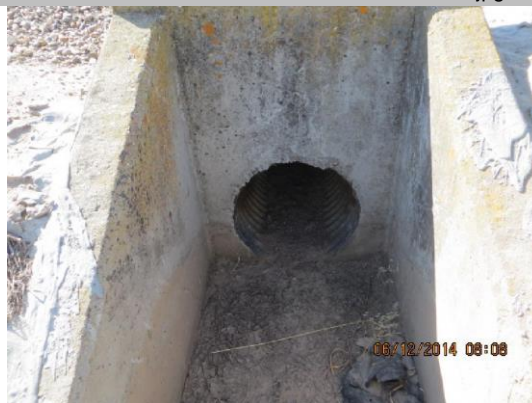
Photo 3 of 3 : UCIP_FA_2019_38555_70601.jpg

Headwall at LS toe.

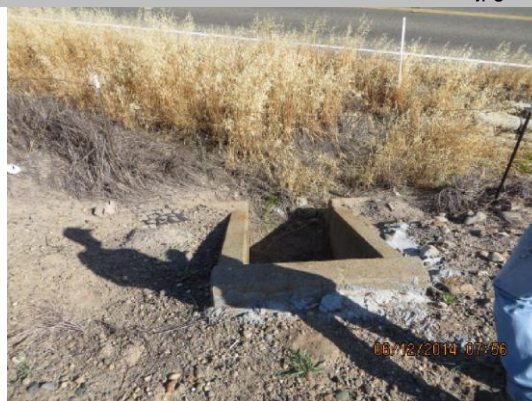
Photo 1 of 3 : UCIP_FA_2019_38552_70590.jpg

LM Start	2.04	Rating **	A/W	Issue No.	218
LM End	2.04	Issue Type +	Ma	Location *	
Category	Supplemental			GPS Latitude/Longitude	
				Start	End
Item	DRAFT DWR UCIP LMA Responsibility			38.117176°	38.117176°
				-121.154019°	-121.154019°
DWR ID	23874				
Comment Code					
Inspector Comment					
DS_ID:23874					
FS_ID:38552					
EP_NO: N/A					
Repair Type: No Action Needed					
Crossing Status: Found					
UCIP Comments:					
FIELD_STRUCT_DESC: 24-inch corrugated metal drainage pipe through the levee, 6 feet below the crown. Concrete U-shaped headwall on both ends. Flap gate on the waterside (WS) end. Cobble grouted spillway. Cobble grouted intake on the landside (LS). [Additional Reference(s): DWR Levee Log, 1978. USACE San Joaquin O&M Manual 612.2, 1967, (HLM 2.05)].					
FS Date: 6/12/2014

Headwall at LS toe.

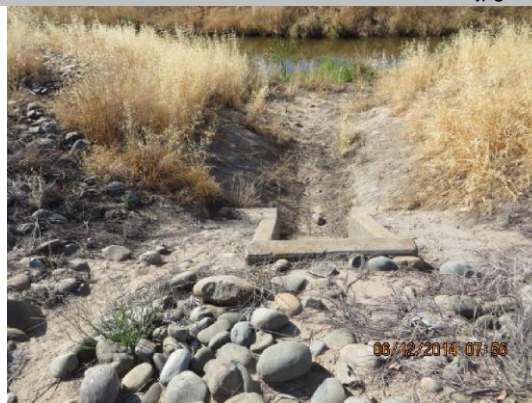
Photo 2 of 3 : UCIP_FA_2019_38552_70589.jpg

Headwall, flapgate, and grouted spillway on WS slope.

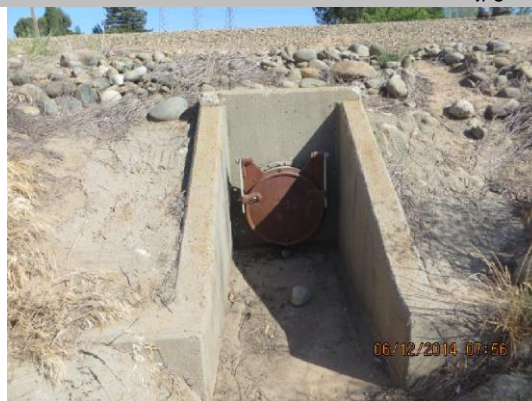
Photo 3 of 3 : UCIP_FA_2019_38552_70588.jpg

Headwall and flapgate on WS slope.

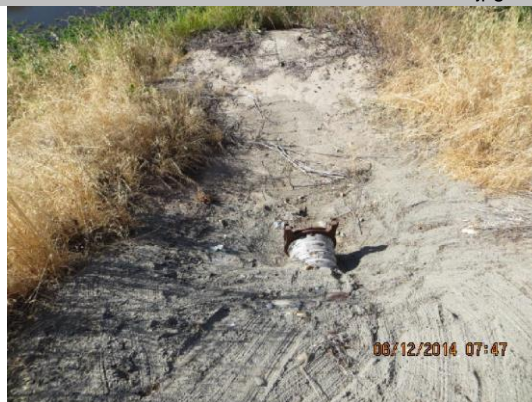
Photo 1 of 3 : UCIP_FA_2019_38551_70586.jpg

LM Start	2.12	Rating **	A/W	Issue No.	219
LM End	2.12	Issue Type +	Ma	Location *	
Category	Supplemental			GPS Latitude/Longitude	
				Start	End
Item	DRAFT DWR UCIP LMA Responsibility			38.117580 °	38.117580 °
				-121.152490 °	-121.152490 °
DWR ID	23875				
Comment Code					
Inspector Comment					
DS_ID:23875					
FS_ID:38551					
EP_NO: N/A					
Repair Type: No Action Needed					
Crossing Status: Found					
UCIP Comments:					
FIELD_STRUCT_DESC: 12-inch corrugated metal drainage pipe through the levee, 5.5 feet below the crown. Flap gate on the waterside (WS) end. Drop inlet with grate at the landside (LS) toe. Spillway cobble grouted. [Additional Reference(s): DWR Levee Log, 1978. USACE San Joaquin O&M Manual 612.2, 1967, (HLM 2.14)].					
FS Date: 6/12/2014

Grouted outlet showing pipe and flapgate on WS slope.

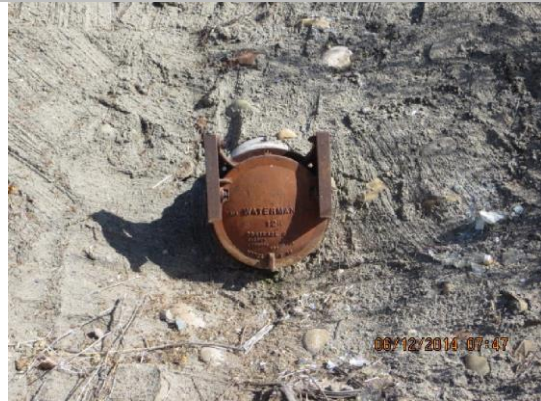
Photo 2 of 3 : UCIP_FA_2019_38551_70585.jpg

Grouted outlet showing pipe and flapgate on WS slope.

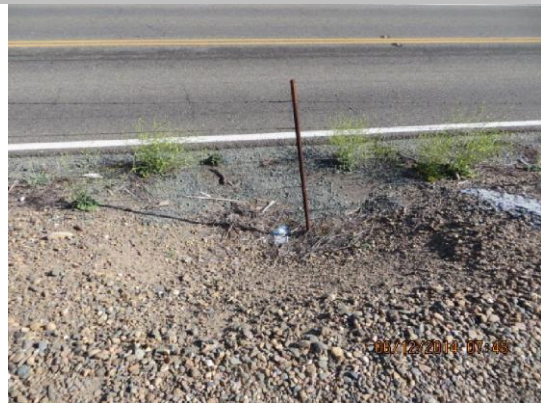
Photo 3 of 3 : UCIP_FA_2019_38551_70584.jpg

Grate over drop-inlet at LS toe next to T-post.

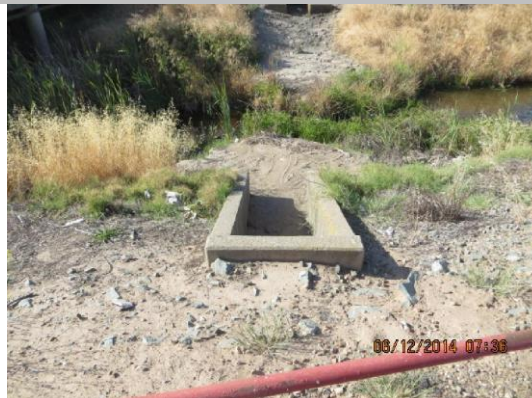
Photo 1 of 3 : UCIP_FA_2019_38550_70583.jpg

LM Start	2.20	Rating **	M	Issue No.	220
LM End	2.20	Issue Type +	Ma	Location *	
Category	Supplemental			GPS Latitude/Longitude	
				Start	End
Item	DRAFT DWR UCIP LMA Responsibility			38.117920 °	38.117920 °
				-121.151120 °	-121.151120 °
DWR ID	23876				
Comment Code					
Inspector Comment					
DS_ID:23876 FS_ID:38550 EP_NO: N/A Repair Type: Non-Urgent Crossing Status: Found UCIP Comments: Concrete inlet at LS of East Kettleman road is damaged...may or may not be a hazard. FIELD_STRUCT_DESC: 24-inch corrugated metal drainage pipe through the levee, 5 feet below the crown. Concrete U-shaped headwall on the waterside (WS) end. Flap gate on the WS end. Cobble grouted spillway. 36-inch concrete catch basin on the landside (LS) end. [Additional Reference(s): DWR Levee Log, 1978. USACE San Joaquin O&M Manual 612.2, 1967, (HLM 2.22)]. FS Date: 6/12/2014

Headwall, flapgate, and grouted spillway on WS slope.

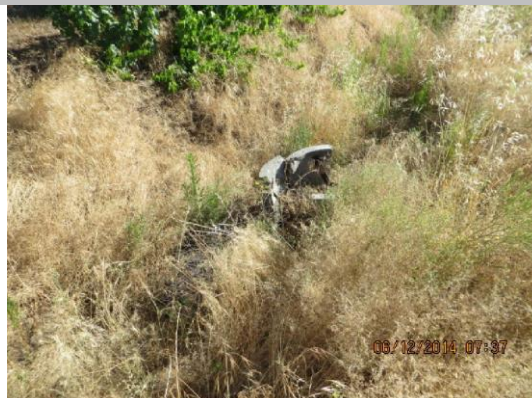
Photo 2 of 3 : UCIP_FA_2019_38550_70582.jpg

Concrete drop-inlet on North side of East Kettleman road damaged.

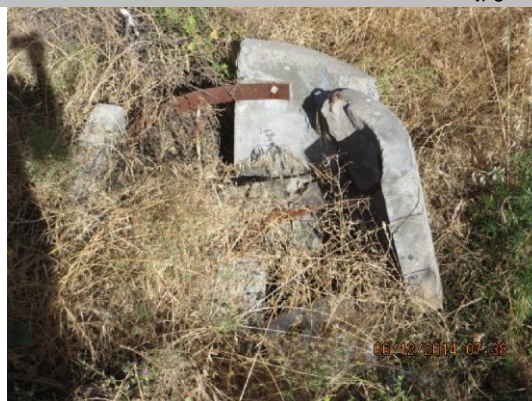
Photo 3 of 3 : UCIP_FA_2019_38550_70581.jpg

Concrete drop-inlet on North side of East Kettleman road damaged.

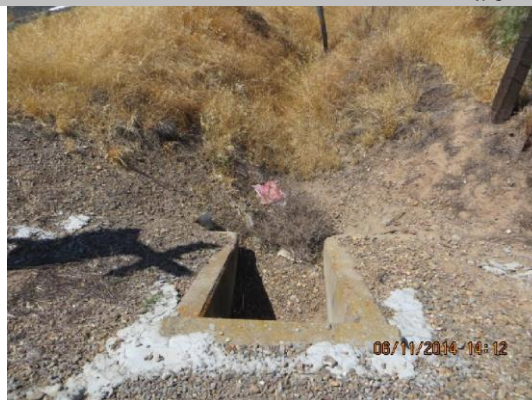
Photo 1 of 3 : UCIP_FA_2019_38548_70576.jpg

LM Start	2.22	Rating **	A/W	Issue No.	223
LM End	2.22	Issue Type +	Ma	Location *	
Category	Supplemental			GPS Latitude/Longitude	
				Start	End
Item	DRAFT DWR UCIP LMA Responsibility			38.118083 °	38.118083 °
				-121.150782 °	-121.150782 °
DWR ID	23878				
Comment Code					
Inspector Comment					
DS_ID:23878 FS_ID:38548 EP_NO: N/A Repair Type: No Action Needed Crossing Status: Found UCIP Comments: FIELD_STRUCT_DESC: 24-inch corrugated metal drainage pipe through the levee, 5 feet below the crown. Concrete U-shaped headwall on both ends. Flap gate on the waterside (WS) end. Cobble grouted spillway. Cobble grouted intake on the landside (LS). [Additional Reference(s): DWR Levee Log, 1978. USACE San Joaquin O&M Manual 612.2, 1967, (HLM 2.24)]. FS Date: 6/11/2014

Headwall at LS toe.

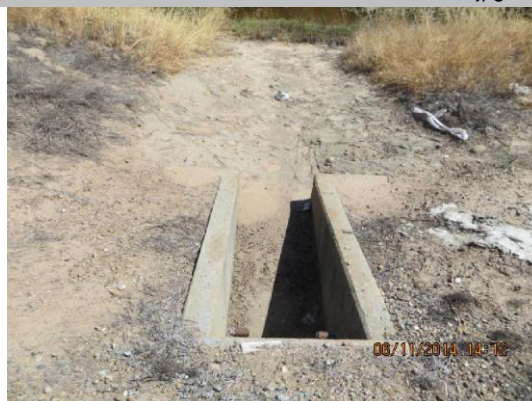
Photo 2 of 3 : UCIP_FA_2019_38548_70575.jpg

Headwall, flapgate, and grouted spillway on WS slope.

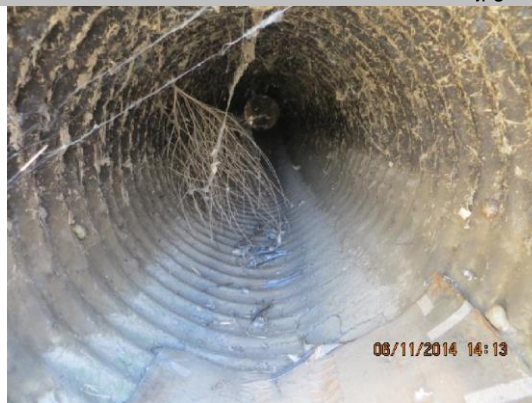
Photo 3 of 3 : UCIP_FA_2019_38548_70574.jpg

Inside pipe at LS toe.
