**Flood Control Project Maintenance
Levee Inspections**

Maintenance Issue Types Only, Levee Inspection Report By Mile - Fall 2019

San Joaquin County Flood Control and Water Conservation District

Waterway	Bank	Unit Miles	Inspection Start/End	Inspector
Unit No. 01 Littlejohn Creek	Left	2.59	11/14/2019 11/14/2019	Alberto De Leon

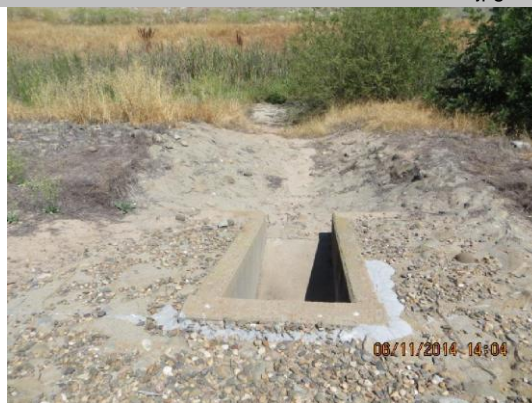
Photo 1 of 3 : UCIP_FA_2019_38546_70571.jpg

LM Start	2.43	Rating **	A/W	Issue No.	224
LM End	2.43	Issue Type +	Ma	Location *	
Category	Supplemental			GPS Latitude/Longitude	
				Start	End
Item	DRAFT DWR UCIP LMA Responsibility			38.119587 °	38.119587 °
				-121.147961 °	-121.147961 °
DWR ID	23886				
Comment Code					
Inspector Comment					
DS_ID:23886					
FS_ID:38546					
EP_NO: N/A					
Repair Type: No Action Needed					
Crossing Status: Found					
UCIP Comments:					
FIELD_STRUCT_DESC: 24-inch corrugated metal drainage pipe through the levee, 4.5 feet below the crown. Concrete U-shaped headwall on both ends. Flap gate on the waterside (WS) end. Cobble grouted spillway. Cobble grouted intake on the landside (LS).					
[Additional Reference(s): DWR Levee Log, 1978. USACE San Joaquin O&M Manual 612.2, 1967, (HLM 2.44)].					
FS Date: 6/11/2014

Headwall, flapgate, and grouted spillway on WS slope.

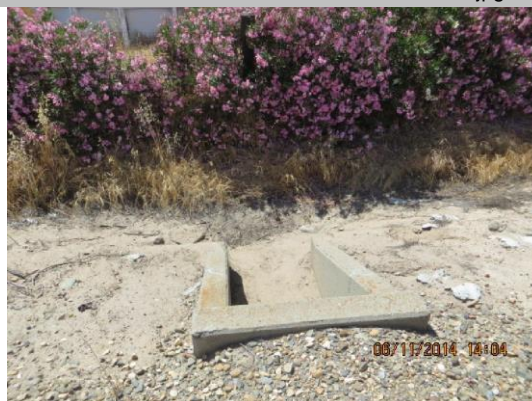
Photo 2 of 3 : UCIP_FA_2019_38546_70570.jpg

Headwall at LS toe.

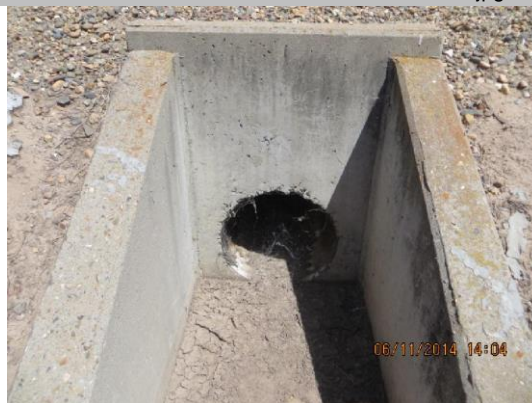
Photo 3 of 3 : UCIP_FA_2019_38546_70569.jpg

Headwall at LS toe.

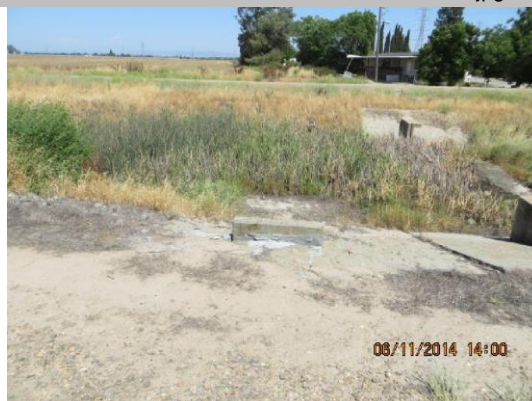
Photo 1 of 3 : UCIP_FA_2019_38545_70566.jpg

LM Start	2.46	Rating **	A/W	Issue No.	225
LM End	2.46	Issue Type +	Ma	Location *	
Category	Supplemental			GPS Latitude/Longitude	
				Start	End
Item	DRAFT DWR UCIP LMA Responsibility			38.120062 °	38.120062 °
				-121.147791 °	-121.147791 °
DWR ID	23887				
Comment Code					
Inspector Comment					
DS_ID:23887					
FS_ID:38545					
EP_NO: N/A					
Repair Type: No Action Needed					
Crossing Status: Found					
UCIP Comments:					
FIELD_STRUCT_DESC: 24-inch corrugated metal drainage pipe through the levee, 5.5 feet below the crown. Concrete U-shaped headwall on both ends. Flap gate on the waterside (WS) end. Cobble grouted spillway. Cobble grouted intake on the landside (LS). [Additional Reference(s): DWR Levee Log, 1978. USACE San Joaquin O&M Manual 612.2, 1967, (HLM 2.48)].					
FS Date: 6/11/2014

Headwall, flapgate, and grouted spillway on WS slope.

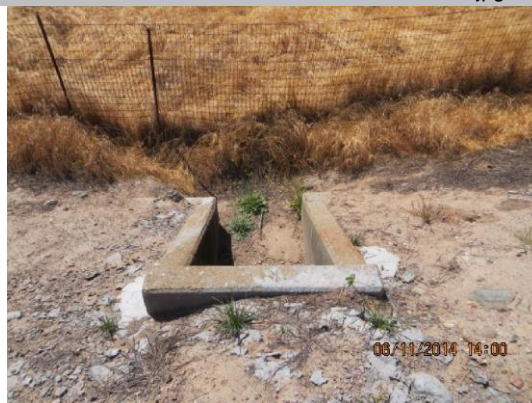
Photo 2 of 3 : UCIP_FA_2019_38545_70565.jpg

Headwall at LS toe.

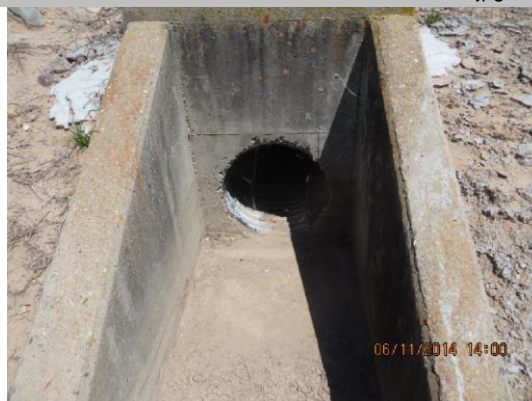
Photo 3 of 3 : UCIP_FA_2019_38545_70564.jpg

Headwall at LS toe.

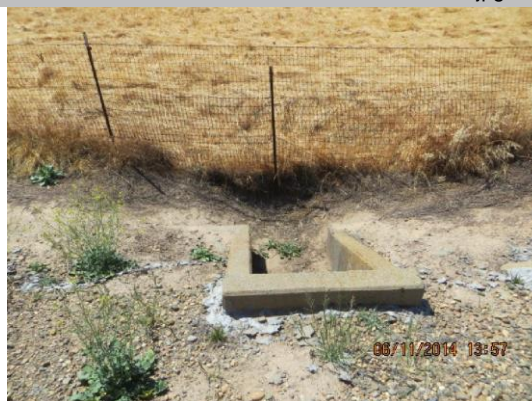
Photo 2 of 3 : UCIP_FA_2019_38544_70560.jpg

Headwall at LS toe.

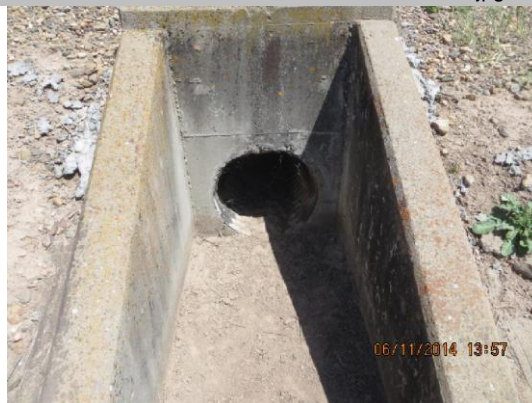
Photo 3 of 3 : UCIP_FA_2019_38544_70559.jpg

Headwall at LS toe.

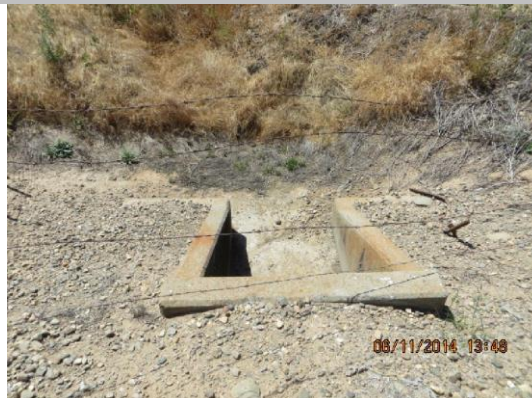
Photo 1 of 3 : UCIP_FA_2019_38542_70554.jpg

LM Start	2.71	Rating **	A/W	Issue No.	228
LM End	2.71	Issue Type +	Ma	Location *	
Category	Supplemental			GPS Latitude/Longitude	
				Start	End
Item	DRAFT DWR UCIP LMA Responsibility			38.122345 °	38.122345 °
				-121.144949 °	-121.144949 °
DWR ID	23890				
Comment Code					
Inspector Comment					
DS_ID:23890 FS_ID:38542 EP_NO: N/A Repair Type: No Action Needed Crossing Status: Found UCIP Comments: FIELD_STRUCT_DESC: 36-inch corrugated metal drainage pipe through the levee, 7 feet below the crown. Concrete U-shaped headwall on both ends. Flap gate on the waterside (WS) end. Cobble grouted spillway. Cobble grouted intake on the landside (LS). (Positive closure device installed on intake end under Permit No. 17426, 2003 - Western Dairy Design Associates, Inc.). [Additional Reference(s): DWR Levee Log, 1978. USACE San Joaquin O&M Manual 612.2, 1967, (HLM 2.73)]. FS Date: 6/11/2014

Headwall at LS toe.

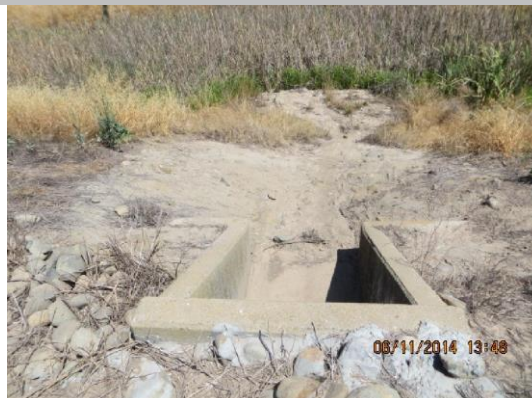
Photo 2 of 3 : UCIP_FA_2019_38542_70553.jpg

Headwall, flapgate, and grouted spillway on WS slope.

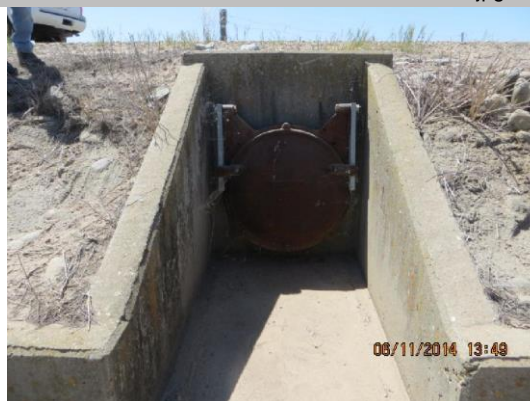
Photo 3 of 3 : UCIP_FA_2019_38542_70552.jpg

Headwall and flapgate on WS slope.

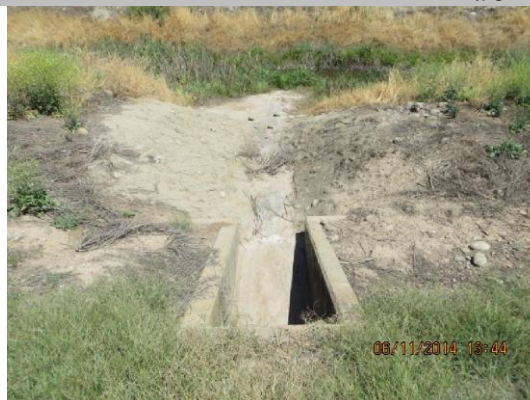
Photo 1 of 3 : UCIP_FA_2019_38541_70550.jpg

Headwall, flapgate, and grouted spillway on WS slope.

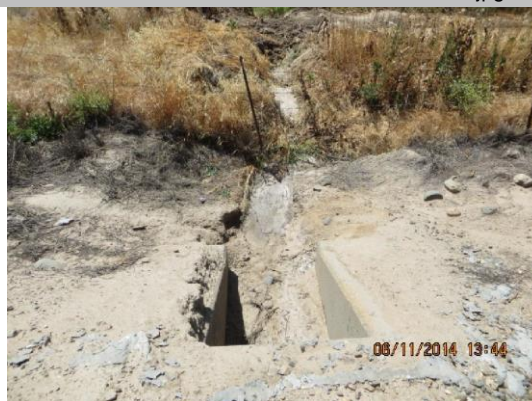
Photo 2 of 3 : UCIP_FA_2019_38541_70549.jpg

Headwall at LS toe.

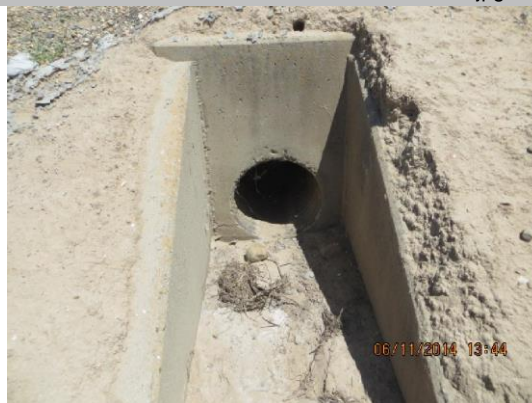
Photo 3 of 3 : UCIP_FA_2019_38541_70548.jpg

Headwall at LS toe.

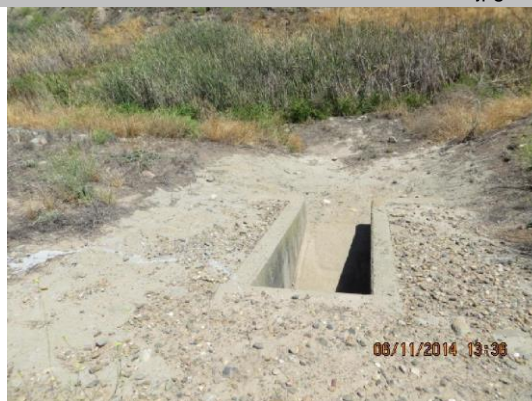
Photo 1 of 3 : UCIP_FA_2019_38539_70546.jpg

Comment Code						
Inspector Comment						
DS_ID:23892						
FS_ID:38539						
EP_NO: N/A						
Repair Type: Non-Urgent						
Crossing Status: Found						
UCIP Comments: Pipe abandoned and if so should be done so properly. Verify if possible pipe filled with concrete.						
FIELD_STRUCT_DESC: *ABANDONED* 24-inch corrugated metal drainage pipe through the levee, 6.5 feet below the crown. Concrete U-shaped headwall on both ends. Flap gate on the waterside (WS) end. Cobble grouted spillway. Cobble grouted intake on the landside (LS). (Intake end plugged, and pipe filled with concrete under Permit No. 17426, 2003 - Western Dairy Design Associates, Inc.). [Additional Reference(s): DWR Levee Log, 1978. USACE San Joaquin O&M Manual 612.2, 1967, (HLM 3.04)].						
FS Date: 6/11/2014

Headwall, flapgate, and grouted spillway on WS slope.

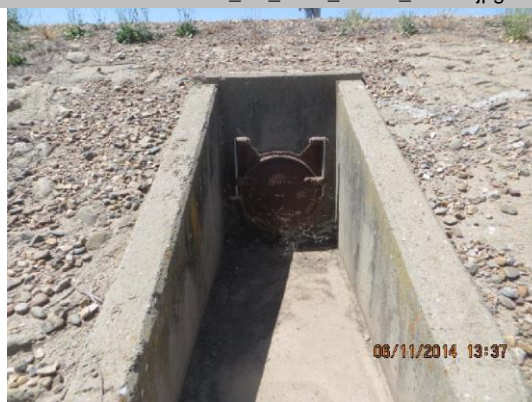
Photo 2 of 3 : UCIP_FA_2019_38539_70545.jpg

Headwall and flapgate on WS slope.

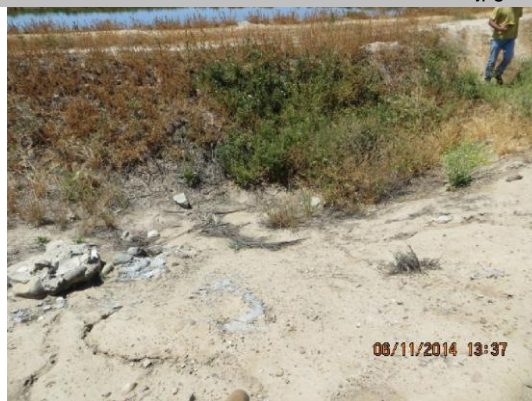
Photo 3 of 3 : UCIP_FA_2019_38539_70544.jpg

Comment Code						
Inspector Comment						
DS_ID:23892 FS_ID:38539 EP_NO: N/A Repair Type: Non-Urgent Crossing Status: Found UCIP Comments: Pipe abandoned and if so should be done so properly. Verify if possible pipe filled with concrete. FIELD_STRUCT_DESC: *ABANDONED* 24-inch corrugated metal drainage pipe through the levee, 6.5 feet below the crown. Concrete U-shaped headwall on both ends. Flap gate on the waterside (WS) end. Cobble grouted spillway. Cobble grouted intake on the landside (LS). (Intake end plugged, and pipe filled with concrete under Permit No. 17426, 2003 - Western Dairy Design Associates, Inc.). [Additional Reference(s): DWR Levee Log, 1978. USACE San Joaquin O&M Manual 612.2, 1967, (HLM 3.04)]. FS Date: 6/11/2014

LS filled in with concrete per notes.

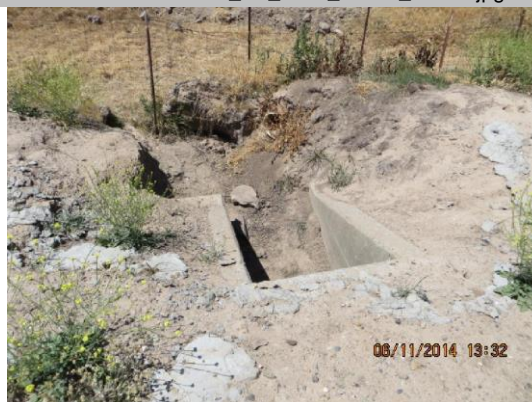
Photo 1 of 3 : UCIP_FA_2019_38538_70541.jpg

Headwall at LS toe.

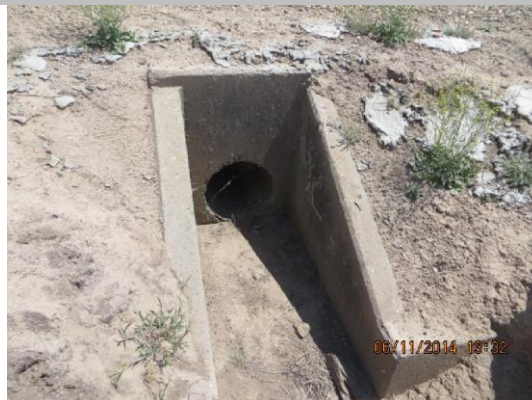
Photo 3 of 3 : UCIP_FA_2019_38538_70539.jpg

Headwall at LS toe.

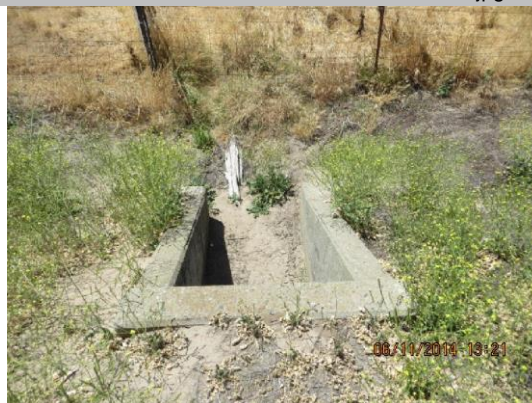
Photo 2 of 3 : UCIP_FA_2019_38536_70533.jpg

Headwall at LS toe.

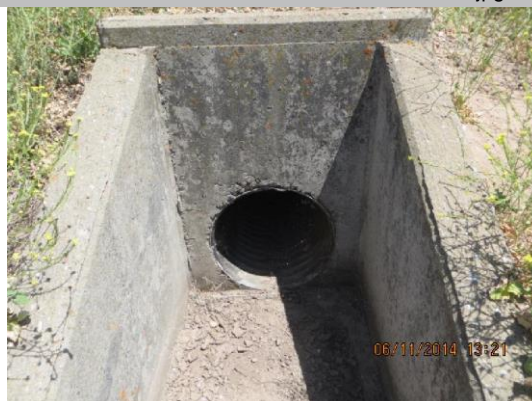
Photo 3 of 3 : UCIP_FA_2019_38536_70532.jpg

Headwall at LS toe.

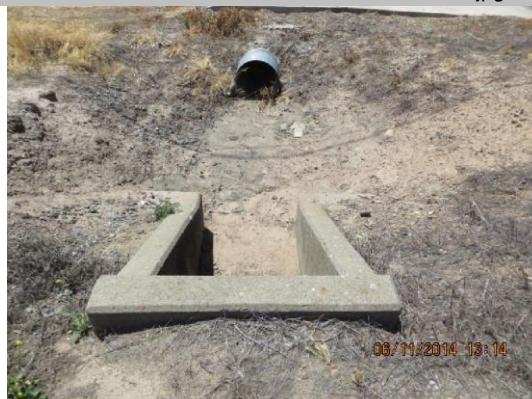
Photo 1 of 3 : UCIP_FA_2019_38535_70529.jpg

Headwall at LS toe.

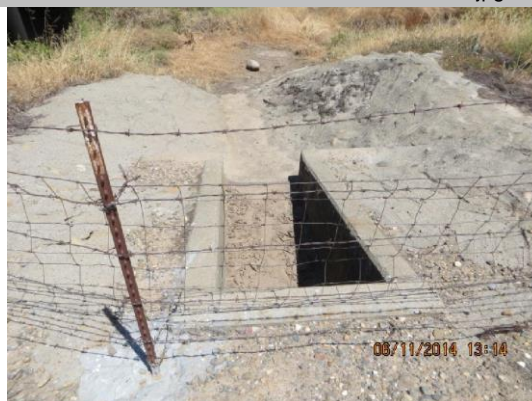
Photo 2 of 3 : UCIP_FA_2019_38535_70528.jpg

Headwall, flapgate, and grouted spillway on WS slope.

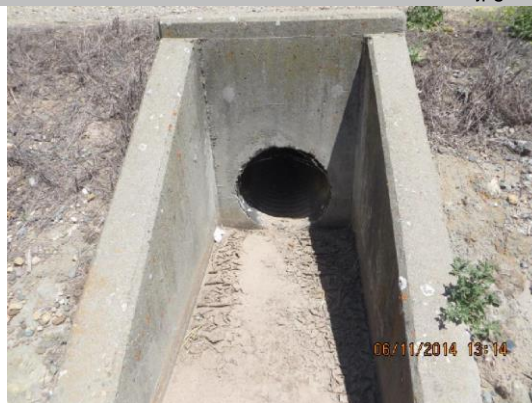
Photo 3 of 3 : UCIP_FA_2019_38535_70527.jpg

Headwall at LS toe.

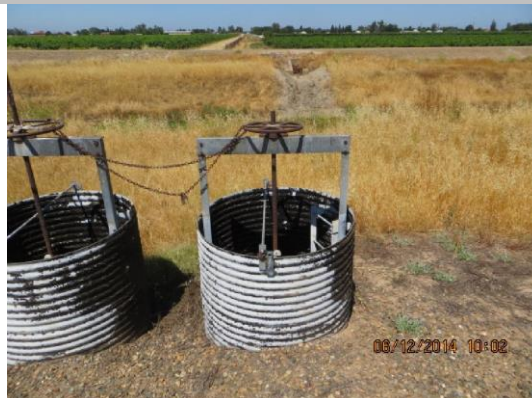
Photo 1 of 3 : UCIP_FA_2019_40788_70672.jpg

Comment Code						
Inspector Comment						
DS_ID:23925						
FS_ID:40788						
EP_NO: N/A						
Repair Type: Non-Urgent						
Crossing Status: Found						
UCIP Comments: Gate valve rusted in place. No lid or cover on Standpipe on WS slope.						
FIELD_STRUCT_DESC: 1 of 2: 42-inch corrugated metal drainage pipe through the levee, 7 feet below the crown. Slide gate in a 56-inch corrugated metal riser unit on the waterside (WS) slope. Flap gate on the WS end. Concrete headwall on both ends. [Additional Reference(s): DWR Levee Log, 1978. USACE San Joaquin O&M Manual 612.2, 1967, (HLM 0.14) 36-inch pipe listed].						
FS Date: 6/12/2014

Slidegate in CMP riser on WS slope. No lid and gate rusted in place.

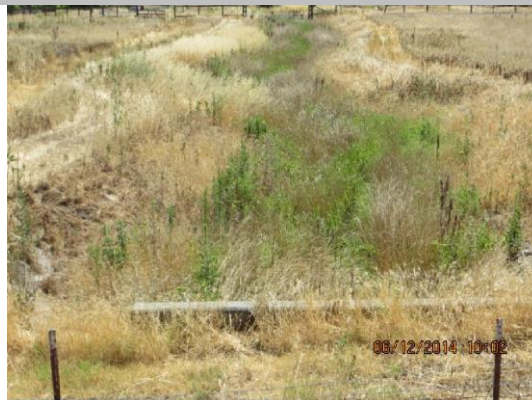
Photo 2 of 3 : UCIP_FA_2019_40788_70671.jpg

Headwall on LS toe.

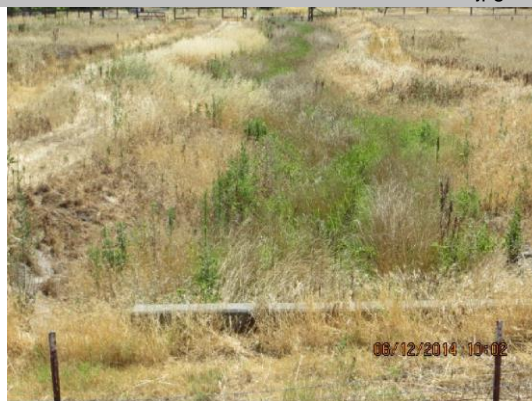
Photo 2 of 3 : UCIP_FA_2019_38569_70668.jpg

DS_ID:23930
FS_ID:38569
EP_NO: N/A
Repair Type: Non-Urgent
Crossing Status: Found
UCIP Comments: No lid on riser and slide gate actuator rusted in place.
FIELD_STRUCT_DESC: 2 of 2: 42-inch corrugated metal drainage pipe through the levee, 7 feet below the crown. Slide gate in 56-inch corrugated metal riser unit on the waterside (WS) slope. Flap gate on the WS end. [Additional Reference(s): DWR Levee Log, 1978. USACE San Joaquin O&M Manual 612.2, 1967, (HLM 0.14) 36-inch pipe listed].
FS Date: 6/12/2014

Headwall at LS toe not accessible

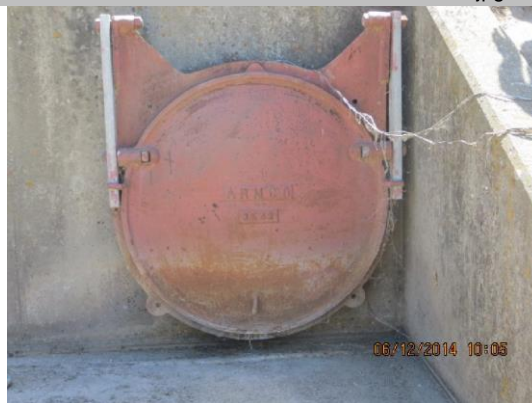
Photo 3 of 3 : UCIP_FA_2019_38569_70667.jpg

Headwall and flapgate on WS slope.

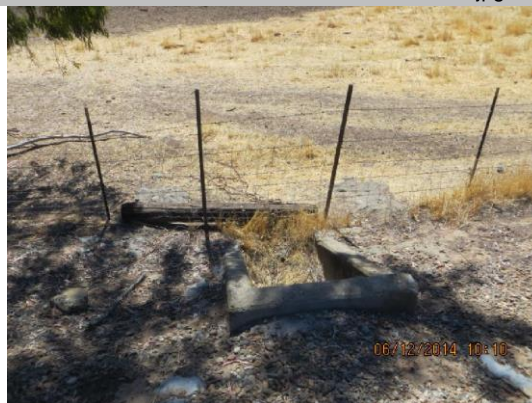
Photo 2 of 3 : UCIP_FA_2019_38573_70674.jpg

Headwall at LS toe.

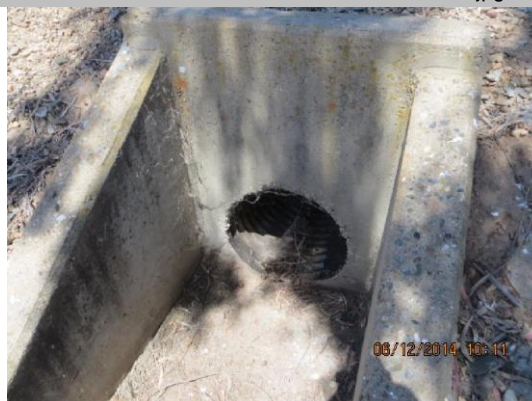
Photo 3 of 3 : UCIP_FA_2019_38573_70673.jpg

Headwall at LS toe.

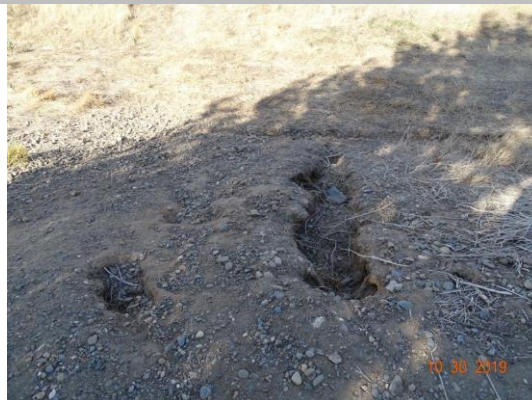
Photo 1 of 2 : FA_2019_NA0017_156_45_20191117_00095.jpg

LM Start	0.43	Rating **	M	Issue No.	45
LM End	0.43	Issue Type +	Ma	Location *	WS
Category	Earthen Levee			GPS Latitude/Longitude	
				Start	End
Item	Erosion / Bank Caving			38.101218 °	38.101218 °
				-121.168226 °	-121.168226 °
DWR ID	DWR_NA0017_12_s_2018_45				
Comment Code					
E2 : Schedule repair of erosion site prior to the next inspection.					
Inspector Comment					
Erosion on waterside caused by drainage pipe.

View of erosion caused by an irrigation drainage pipe coming from the landside property. Fall 2019

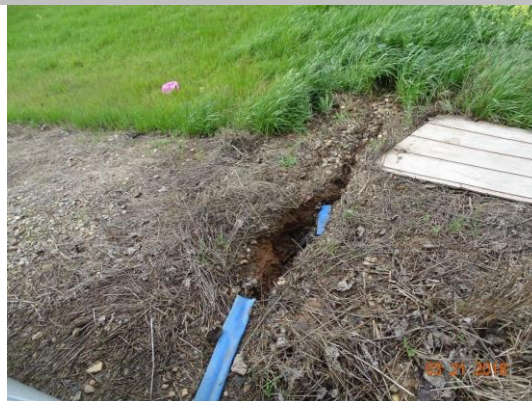
Photo 2 of 2 : FA_2019_NA0017_156_45_20190830_00014.jpg

Erosion caused by pipe outfall on waterside.

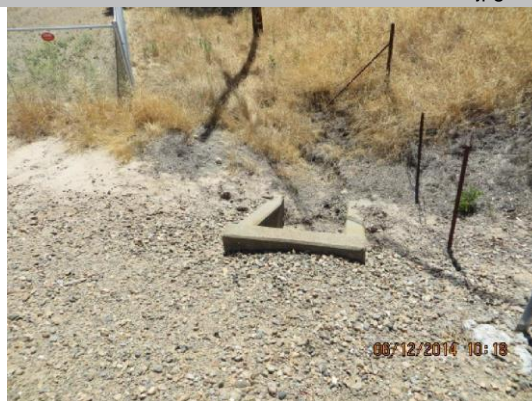
Photo 1 of 3 : UCIP_FA_2019_38574_70680.jpg

Headwall at LS toe.

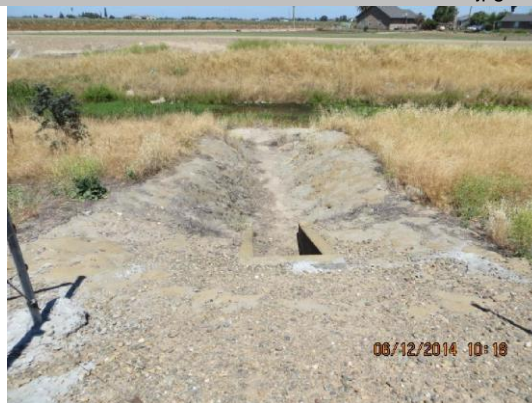
Photo 2 of 3 : UCIP_FA_2019_38574_70679.jpg

Headwall, flapgate, and grouted spillway on WS slope.

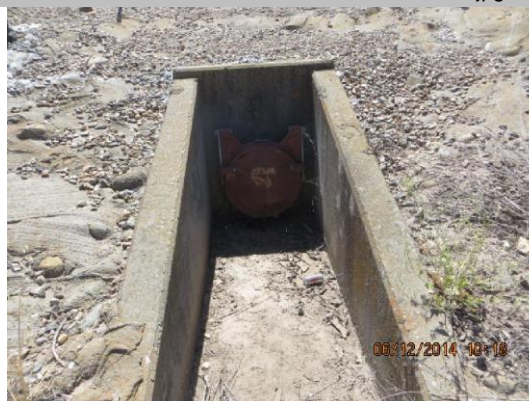
Photo 3 of 3 : UCIP_FA_2019_38574_70678.jpg

Headwall and flapgate on WS slope.

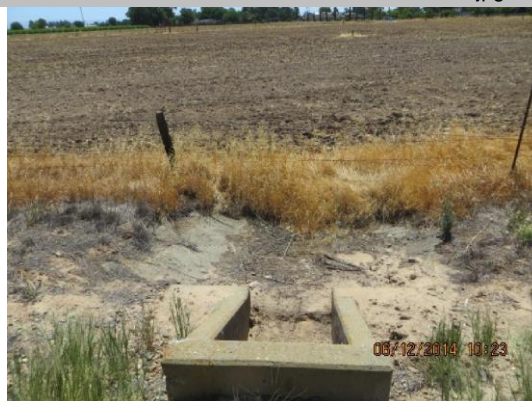
Photo 1 of 3 : UCIP_FA_2019_38576_70690.jpg

Headwall at LS toe.

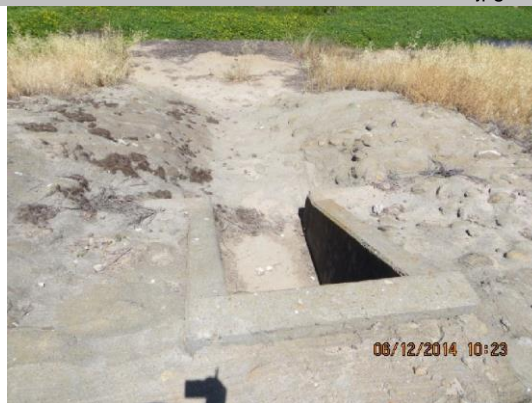
Photo 2 of 3 : UCIP_FA_2019_38576_70689.jpg

Headwall, flapgate, and grouted spillway on WS slope.

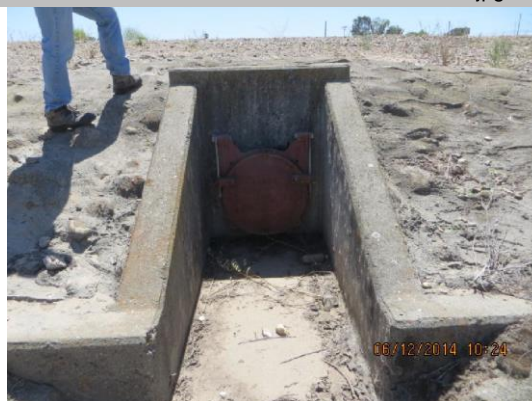
Photo 3 of 3 : UCIP_FA_2019_38576_70688.jpg

Headwall and flapgate on WS slope.

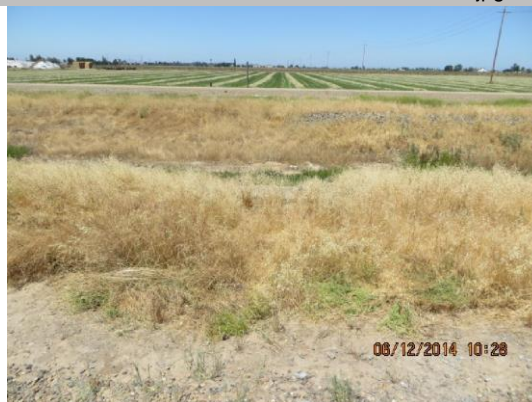
Photo 1 of 3 : UCIP_FA_2019_38577_70695.jpg

Headwall, flapgate, and grouted spillway on WS slope.

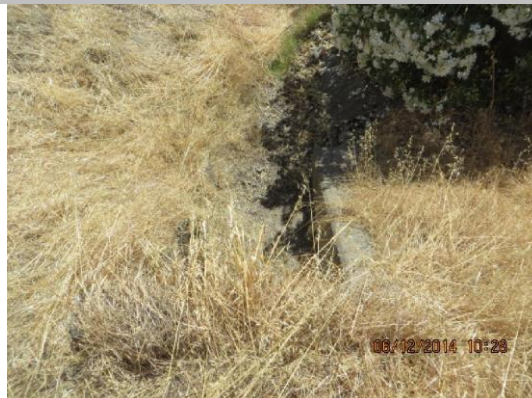
Photo 2 of 3 : UCIP_FA_2019_38577_70694.jpg

Headwall at LS toe.

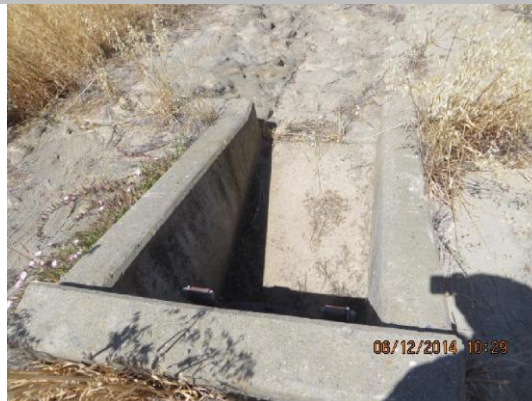
Photo 3 of 3 : UCIP_FA_2019_38577_70693.jpg

Headwall, flapgate, and grouted spillway on WS slope.

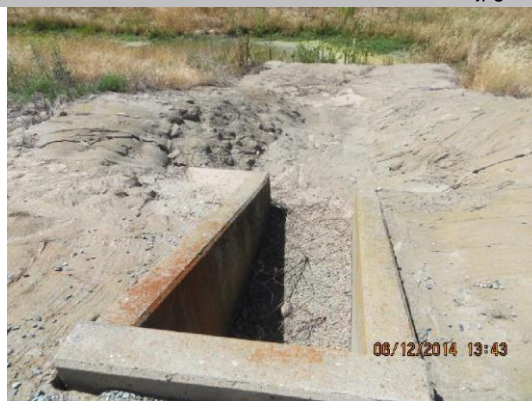
Photo 1 of 3 : UCIP_FA_2019_38624_70787.jpg

Headwall, flapgate, and grouted spillway on WS slope.

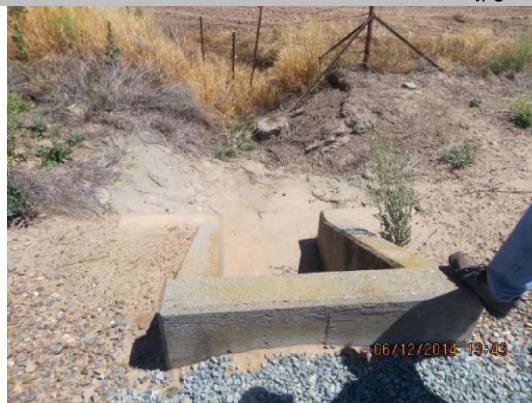
Photo 2 of 3 : UCIP_FA_2019_38624_70786.jpg

Headwall at LS toe.

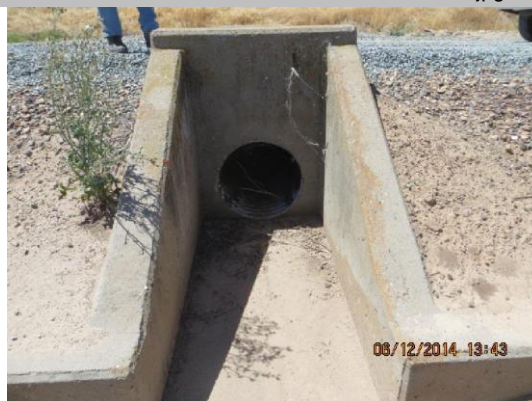
Photo 3 of 3 : UCIP_FA_2019_38624_70785.jpg

Headwall at LS toe.

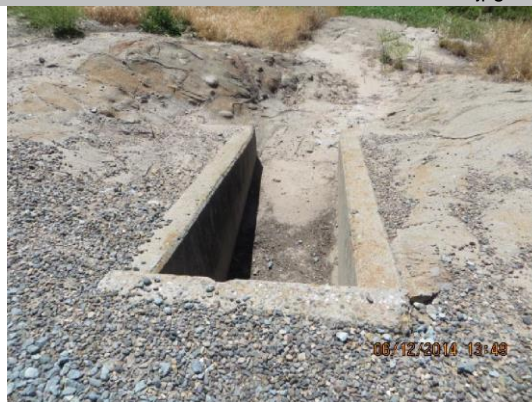
Photo 1 of 3 : UCIP_FA_2019_38626_70795.jpg

Headwall, flapgate, and grouted spillway on WS slope.

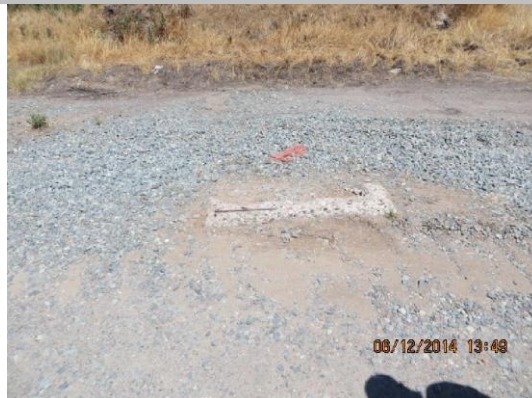
Photo 2 of 3 : UCIP_FA_2019_38626_70794.jpg

Headwall at LS toe buried in soil.

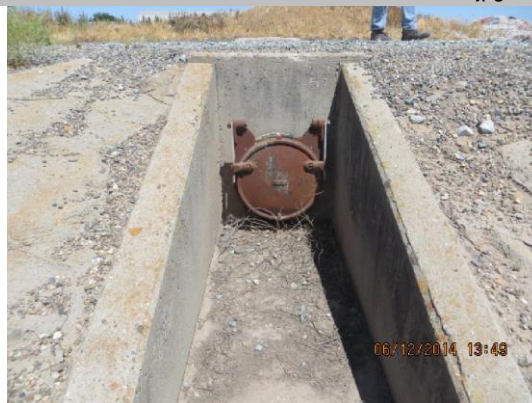
Photo 3 of 3 : UCIP_FA_2019_38626_70793.jpg

Headwall and flapgate on WS slope.

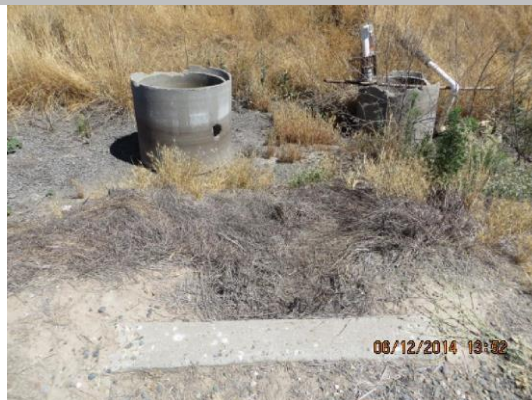
Photo 2 of 2 : UCIP_FA_2019_38627_70796.jpg

Comment Code						
Inspector Comment						
DS_ID:23906						
FS_ID:38627						
EP_NO: N/A						
Repair Type: Non-Urgent						
Crossing Status: Found						
UCIP Comments: Pipe burried on both ends and appears to be abandoned. IF so, it should be done so properly.						
FIELD_STRUCT_DESC: 24-inch corrugated metal drainage pipe through the levee, 4 feet below the crown. Concrete U-shaped headwall on both ends. Flap gate on the waterside (WS) end. Cobble grouted spillway. Cobble grouted intake on the landside (LS). [Additional Reference(s): DWR Levee Log, 1978. USACE San Joaquin O&M Manual 612.2, 1967, (HLM 1.96)].						
FS Date: 6/12/2014

Headwall buried on LS shoulder.

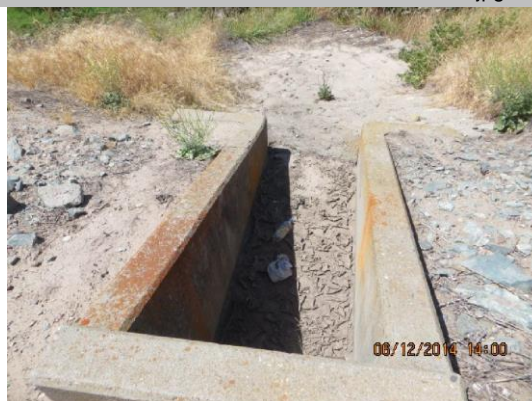
Photo 1 of 3 : UCIP_FA_2019_38629_70805.jpg

Headwall, flapgate, and grouted spillway on WS slope.

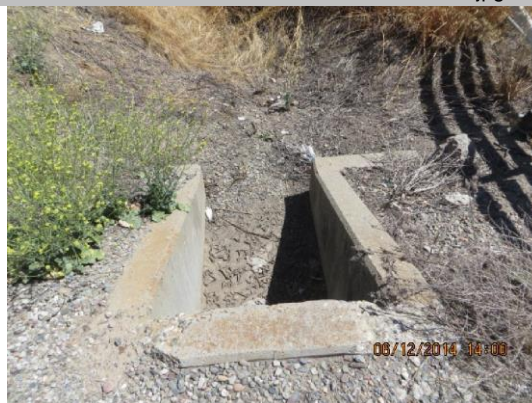
Photo 2 of 3 : UCIP_FA_2019_38629_70804.jpg

Headwall at LS toe.

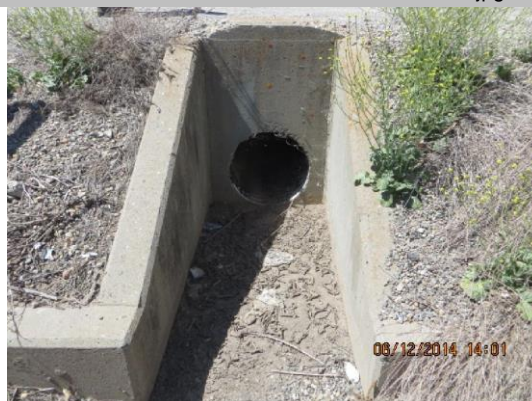
Photo 3 of 3 : UCIP_FA_2019_38629_70803.jpg

Headwall at LS toe.

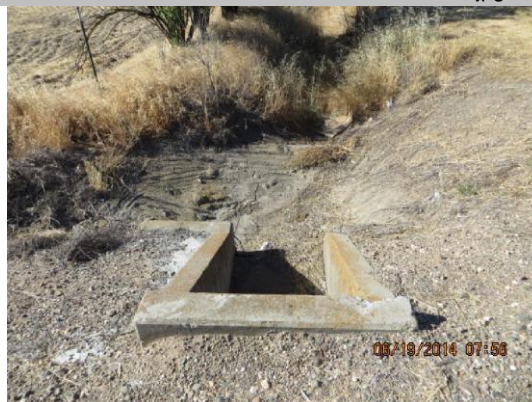
Photo 1 of 3 : UCIP_FA_2019_38630_70810.jpg

Headwall at LS toe.

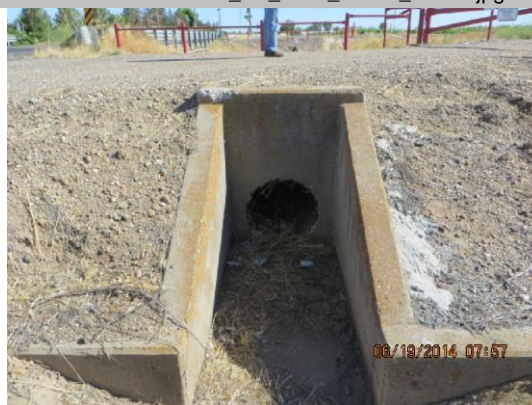
Photo 3 of 3 : UCIP_FA_2019_38630_70808.jpg

Headwall at LS toe.

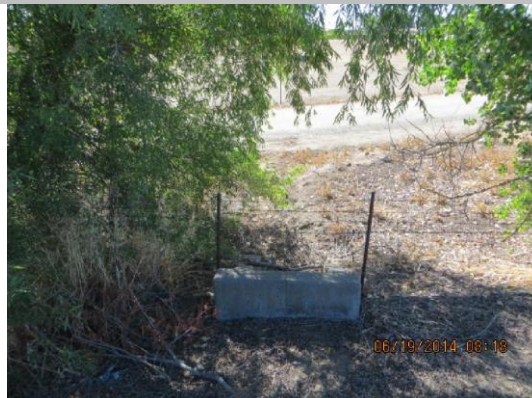
Photo 1 of 3 : UCIP_FA_2019_38632_70815.jpg

Headwall at LS toe.

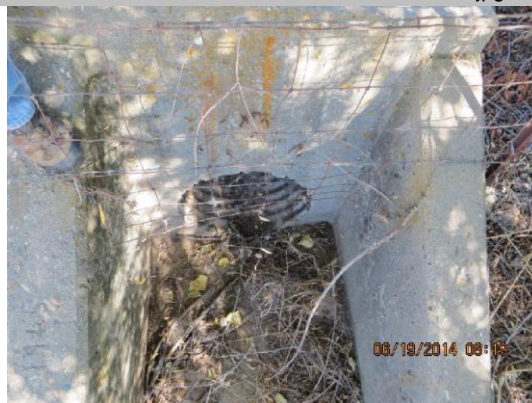
Photo 2 of 3 : UCIP_FA_2019_38632_70814.jpg

Headwall at LS toe.

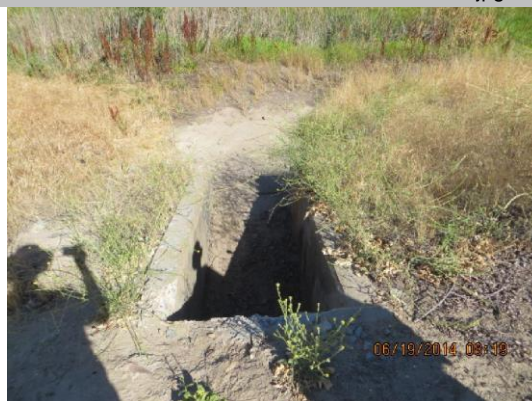
Photo 3 of 3 : UCIP_FA_2019_38632_70813.jpg

Headwall, flapgate, and grouted spillway on WS slope.

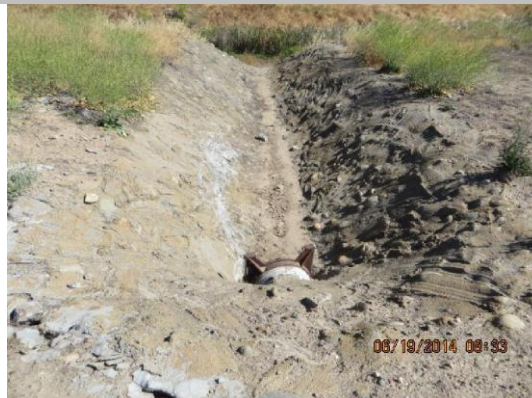
Photo 1 of 3 : UCIP_FA_2019_51630_70822.jpg

Comment Code						
Inspector Comment						
DS_ID:23913 FS_ID:51630 EP_NO: N/A Repair Type: Non-Urgent Crossing Status: Found UCIP Comments: 11/04/2016 Crossing has been downgraded from Urgent to Non-Urgent the silt buildup in front of the flapgate on the WS has been removed, however the sediment buildup inside the crossing still remains. Recommend clearing the sediment buildup inside the pipe and complete an internal integrity inspection to confirm crossing is in good condition. (O. Magana - DWR UCIP) 06/19/2014 Silt buildup on WS toe blocking flapgate operation. (W. Wylie - DWR UCIP) FIELD_STRUCT_DESC: 24-inch corrugated metal drainage pipe through the levee, 4 feet below the crown. Flap gate is located on the waterside (WS) end with a cobble grouted spillway. Cobble grouted intake on the landside (LS). [Additional Reference(s): DWR Levee Log, 1977, 1978, 1987, 1990. USACE San Joaquin O&M Manual Unit 612, Part No. 2 - Bear Creel Project, Unit 7: HLM 7.19 – 16.77, Unit 8: HLM 7.55-16.48, Unit 9: HLM 0.10-1.52; Unit 10: HLM 0.03-1.35, Unit 11: HLM 0.16-3.55, Unit 12: HLM 0.14-3.91; Unit 13, HLM 0.03-1.18; Unit 14, HLM 0.02-1.17, 1967, (HLM 2.61)] FS Date: 11/4/2016 8:33:00 AM

Flapgate and grouted spillway on WS slope.

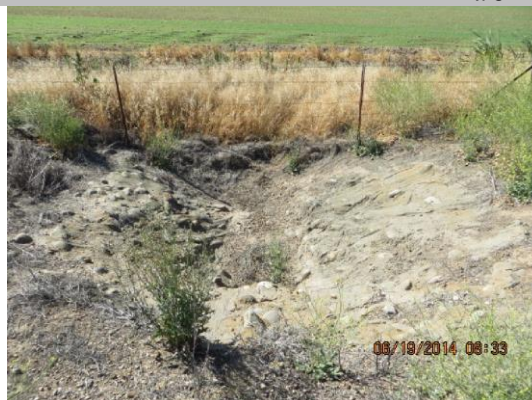
Photo 2 of 3 : UCIP_FA_2019_51630_70821.jpg

Inlet at LS toe.

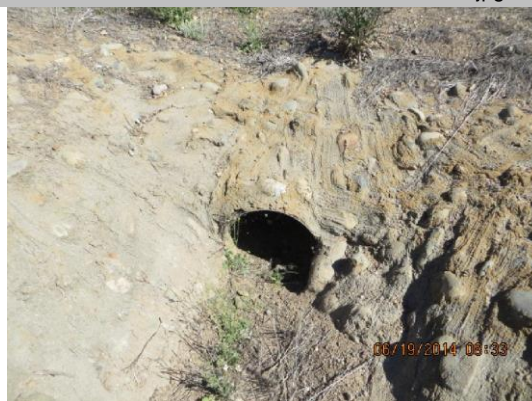
Photo 3 of 3 : UCIP_FA_2019_51630_70820.jpg

Comment Code						
Inspector Comment						
DS_ID:23913 FS_ID:51630 EP_NO: N/A Repair Type: Non-Urgent Crossing Status: Found UCIP Comments: 11/04/2016 Crossing has been downgraded from Urgent to Non-Urgent the silt buildup in front of the flapgate on the WS has been removed, however the sediment buildup inside the crossing still remains. Recommend clearing the sediment buildup inside the pipe and complete an internal integrity inspection to confirm crossing is in good condition. (O. Magana - DWR UCIP) 06/19/2014 Silt buildup on WS toe blocking flapgate operation. (W. Wylie - DWR UCIP) FIELD_STRUCT_DESC: 24-inch corrugated metal drainage pipe through the levee, 4 feet below the crown. Flap gate is located on the waterside (WS) end with a cobble grouted spillway. Cobble grouted intake on the landside (LS). [Additional Reference(s): DWR Levee Log, 1977, 1978, 1987, 1990. USACE San Joaquin O&M Manual Unit 612, Part No. 2 - Bear Creel Project, Unit 7: HLM 7.19 – 16.77, Unit 8: HLM 7.55-16.48, Unit 9: HLM 0.10-1.52; Unit 10: HLM 0.03-1.35, Unit 11: HLM 0.16-3.55, Unit 12: HLM 0.14-3.91; Unit 13, HLM 0.03-1.18; Unit 14, HLM 0.02-1.17, 1967, (HLM 2.61)] FS Date: 11/4/2016 8:33:00 AM

Inlet at LS toe.

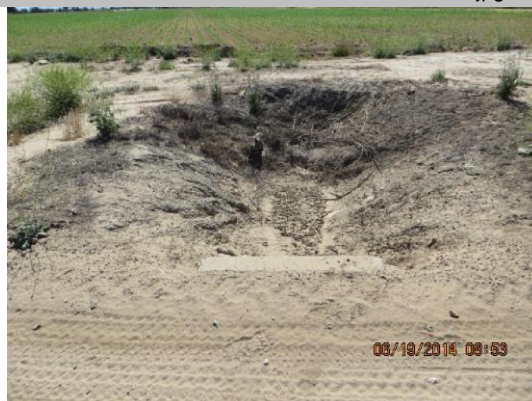
Photo 1 of 3 : UCIP_FA_2019_38636_70832.jpg

LM Start	2.72	Rating **	A/W	Issue No.	129	
LM End	2.72	Issue Type +	Ma	Location *		
Category	Supplemental			GPS Latitude/Longitude		
				Start	End	
Item	DRAFT DWR UCIP LMA Responsibility			38.122733 °	38.122733 °	
				-121.144351 °	-121.144351 °	
DWR ID	23915					
Comment Code						
Inspector Comment						
DS_ID:23915						
FS_ID:38636						
EP_NO: N/A						
Repair Type: No Action Needed						
Crossing Status: Found						
UCIP Comments:						
FIELD_STRUCT_DESC: 12-inch corrugated metal drainage pipe through the levee, 2 feet below the crown. Flap gate on the waterside (WS) end. Cobble grouted spillway. Cobble grouted intake on the landside (LS). [Additional Reference(s): DWR Levee Log, 1978. USACE San Joaquin O&M Manual 612.2, 1967, (HLM 2.72)].						
FS Date: 6/19/2014

Headwall and pipe at LS shoulder.

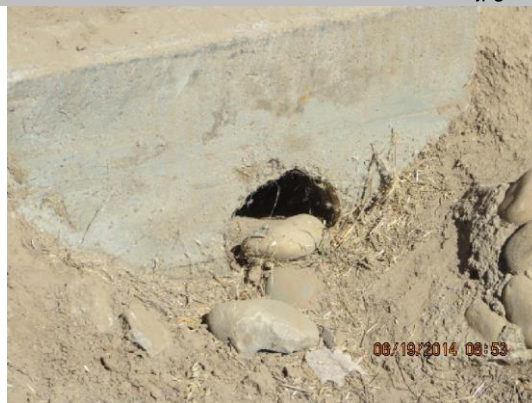
Photo 2 of 3 : UCIP_FA_2019_38636_70831.jpg

Headwall and pipe at LS shoulder.

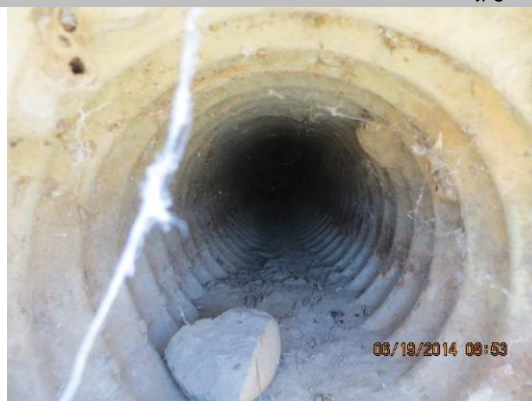
Photo 3 of 3 : UCIP_FA_2019_38636_70830.jpg

Inside pipe on LS shoulder.

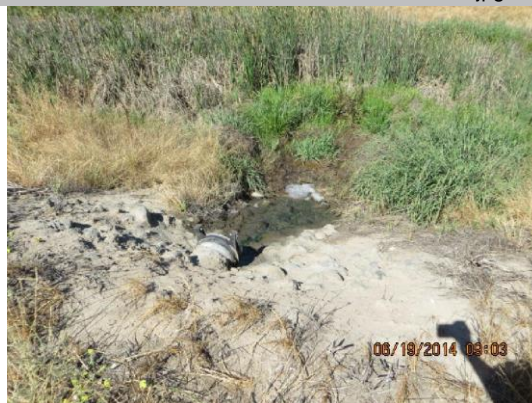
Photo 1 of 3 : UCIP_FA_2019_38638_70838.jpg

LM Start	2.94	Rating **	A/W	Issue No.	130
LM End	2.94	Issue Type +	Ma	Location *	
Category	Supplemental			GPS Latitude/Longitude	
				Start	End
Item	DRAFT DWR UCIP LMA Responsibility			38.125894 °	38.125894 °
				-121.143970 °	-121.143970 °
DWR ID	23916				
Comment Code					
Inspector Comment					
DS_ID:23916					
FS_ID:38638					
EP_NO: N/A					
Repair Type: No Action Needed					
Crossing Status: Found					
UCIP Comments:					
FIELD_STRUCT_DESC: 12-inch corrugated metal drainage pipe through the levee, 3 feet below the crown. Flap gate on the waterside (WS) end. Cobble grouted spillway. (Positive closure device installed on intake end under Permit No. 17426, 2003 - Western Dairy Design Associates, Inc.). [Additional Reference(s): DWR Levee Log, 1978. USACE San Joaquin O&M Manual 612.2, 1967, (HLM 2.95)].					
FS Date: 6/19/2014

Flapgate on CMP pipe at WS slope with grouted spillway.

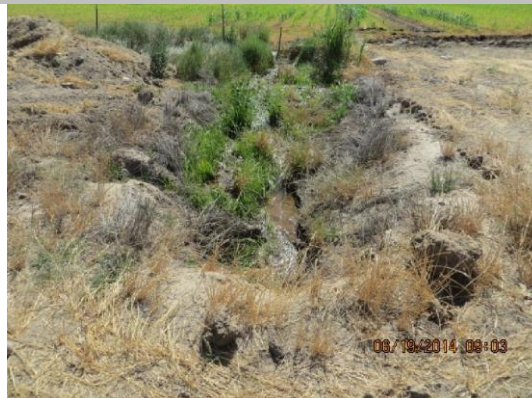
Photo 2 of 3 : UCIP_FA_2019_38638_70837.jpg

Pipe at inlet on LS shoulder.

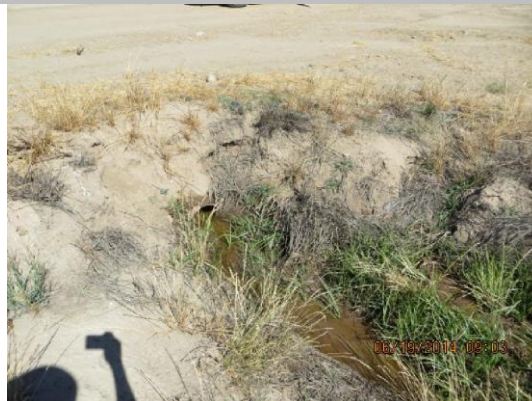
Photo 3 of 3 : UCIP_FA_2019_38638_70836.jpg

Pipe at inlet on LS shoulder.

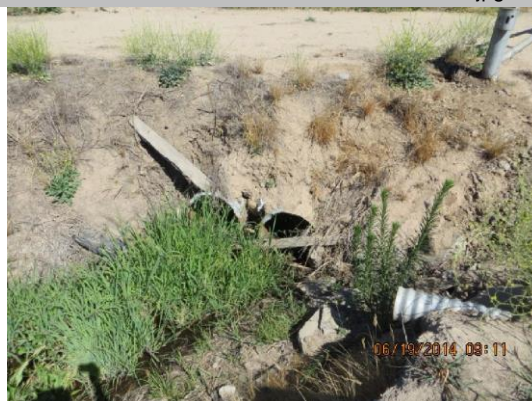
Photo 1 of 3 : UCIP_FA_2019_53519_70848.jpg

Comment Code					
Inspector Comment					
DS_ID:23928 FS_ID:53519 EP_NO: N/A Repair Type: Urgent Crossing Status: Found UCIP Comments: 11/12/2018 NA0017 found corrosion and holes along the bottom of this CMP drainage culvert. Culvert is also open on both ends. Crossing escalated to "Urgent" due to the extensive corrosion that was found. Internal inspection and/or rehabilitation recommended. (A. McDonald - DWR UCIP)Pipe open on both ends. FIELD_STRUCT_DESC: 1 of 2: 24-inch corrugated metal drainage pipe through the levee, 3 feet below the crown. No closure device or flap gate. [Additional Reference(s): USACE San Joaquin O&M Manual 612.2, 1967, (HLM 3.15)]. FS Date: 11/12/2018

Pipe on LS toe.

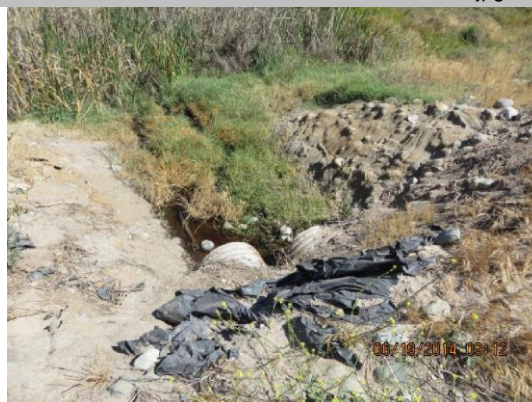
Photo 2 of 3 : UCIP_FA_2019_53519_70847.jpg

Pipe at grouted spillway on WS slope.

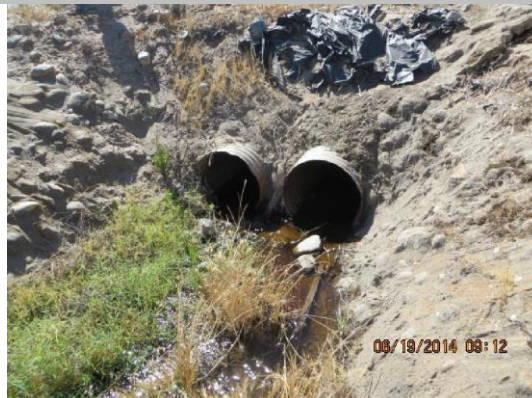
Photo 3 of 3 : UCIP_FA_2019_53519_70846.jpg

Pipe at grouted spillway on WS slope.

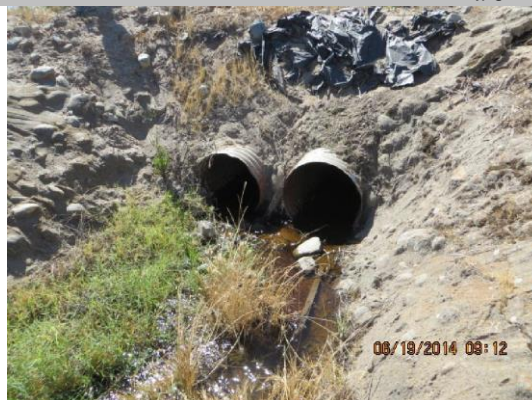
Photo 1 of 3 : UCIP_FA_2019_53520_70853.jpg

Comment Code						
Inspector Comment						
DS_ID:23926 FS_ID:53520 EP_NO: N/A Repair Type: Urgent Crossing Status: Found UCIP Comments: 11/12/2018 NA0017 found corrosion and holes along the bottom of this CMP drainage culvert. Culvert is also open on both ends. Crossing escalated to "Urgent" due to the extensive corrosion that was found. Internal inspection and/or rehabilitation recommended. (A. McDonald - DWR UCIP)Pipe open with no flapgate. FIELD_STRUCT_DESC: 2 of 2: 24-inch corrugated metal drainage pipe through the levee, 3 feet below the crown. No closure device or flap gate. [Additional Reference(s): USACE San Joaquin O&M Manual 612.2, 1967, (HLM 3.15)]. FS Date: 11/12/2018

Pipe visible on WS slope at grouted spillway.

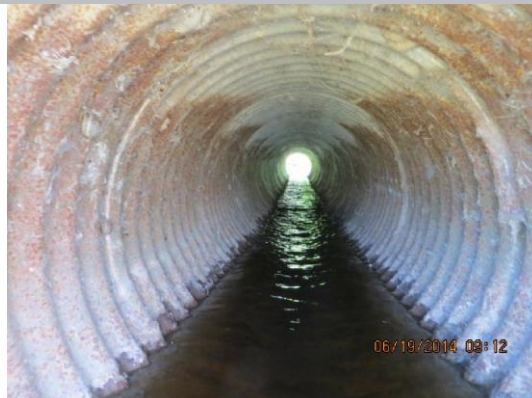
Photo 2 of 3 : UCIP_FA_2019_53520_70852.jpg

Inside pipe at WS slope.

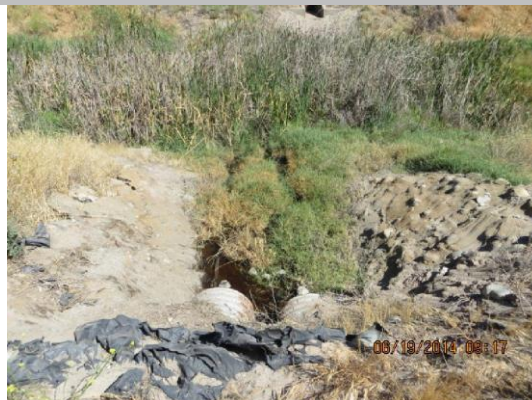
Photo 3 of 3 : UCIP_FA_2019_53520_70851.jpg

Pipe visible on WS slope at grouted spillway.

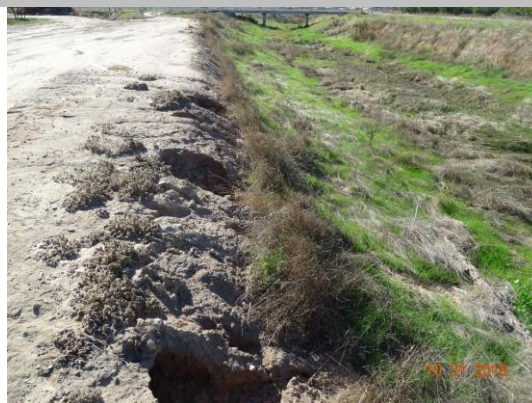
Photo 1 of 1 : FA_2019_NA0017_156_49_20190830_00016.jpg

LM Start	3.13	Rating **	M	Issue No.	49
LM End	3.13	Issue Type +	Ma	Location *	WS
Category	Earthen Levee			GPS Latitude/Longitude	
				Start	End
Item	Erosion / Bank Caving			38.127217 °	38.127217 °
				-121.141445 °	-121.141445 °
DWR ID	DWR_NA0017_12_f_2018_49				
Comment Code					
E2 : Schedule repair of erosion site prior to the next inspection.					
Inspector Comment					
There is runoff erosion on the waterside slope.

View of erosion on the waterside slope. Fall 2018.

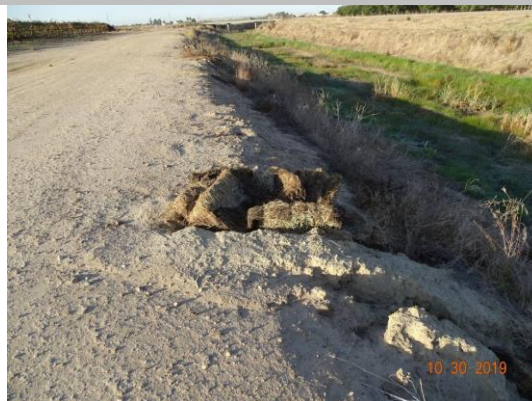
Photo 1 of 3 : FA_2019_NA0017_156_31_20191117_00092.jpg

LM Start	3.14	Rating **	U	Issue No.	31
LM End	3.16	Issue Type +	Ma	Location *	WS
Category	Earthen Levee			GPS Latitude/Longitude	
				Start	End
Item	Erosion / Bank Caving			38.127390 °	38.127487 °
				-121.141197 °	-121.141013 °
DWR ID	DWR_NA0017_12_s_2016_31				
Comment Code					
E2 : Schedule repair of erosion site prior to the next inspection.					
Inspector Comment					
Land owner has placed hay bales as a temporary measure for surface runoff.

View of erosion caused by surface runoff. Land owner has placed hay bales into erosion area. LMA will schedule repair. Fall 2019

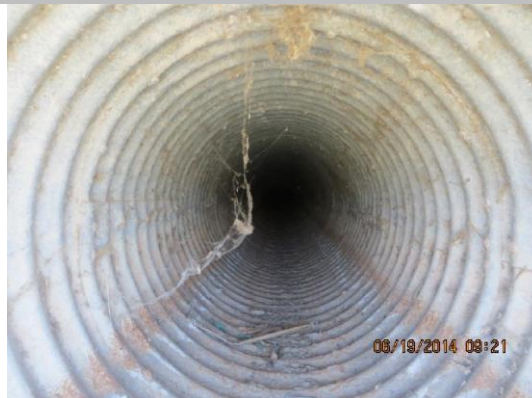
Photo 1 of 3 : UCIP_FA_2019_38643_70857.jpg

DS_ID:23917
FS_ID:38643
EP_NO: N/A
Repair Type: No Action Needed
Crossing Status: Found
UCIP Comments: No flapgate
FIELD_STRUCT_DESC: 24-inch corrugated metal drainage pipe through the levee, 4.5 feet below the crown. Cobble grouted spillway. Cobble grouted intake on the landside (LS). [Additional Reference(s): DWR Levee Log, 1978. USACE San Joaquin O&M Manual 612.2, 1967, (HLM 3.25)].
FS Date: 6/19/2014

Inside pipe at WS slope.

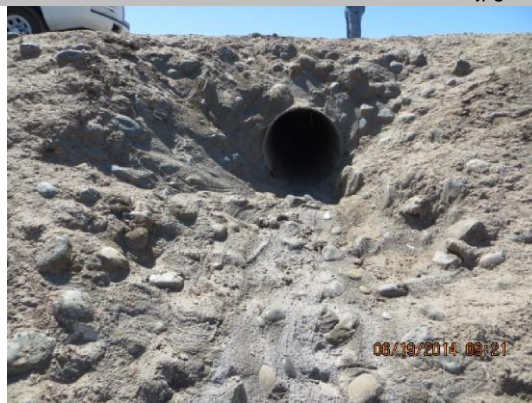
Photo 2 of 3 : UCIP_FA_2019_38643_70856.jpg

Pipe and grouted spillway on WS slope.

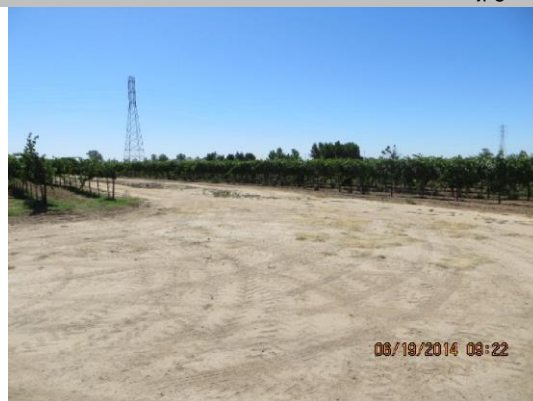
Photo 3 of 3 : UCIP_FA_2019_38643_70855.jpg

Ditch for inlet well off LS shoulder.

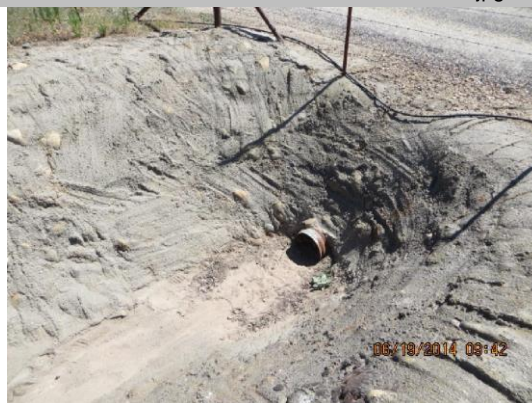
Photo 1 of 3 : UCIP_FA_2019_38646_70866.jpg

LM Start	3.51	Rating **	A/W	Issue No.	135	
LM End	3.51	Issue Type +	Ma	Location *		
Category	Supplemental			GPS Latitude/Longitude		
				Start	End	
Item	DRAFT DWR UCIP LMA Responsibility			38.131725°	38.131725°	
				-121.138422°	-121.138422°	
DWR ID	23920					
Comment Code						
Inspector Comment						
DS_ID:23920						
FS_ID:38646						
EP_NO: N/A						
Repair Type: No Action Needed						
Crossing Status: Found						
UCIP Comments:						
FIELD_STRUCT_DESC: 12-inch corrugated metal drainage pipe						
through the levee, 4.5 feet below the crown. Cobble grouted spillway.						
[Additional Reference(s): DWR Levee Log, 1978. USACE San Joaquin						
O&M Manual 612.2, 1967, (HLM 3.52)].						
FS Date: 6/19/2014

Pipe on WS slope.

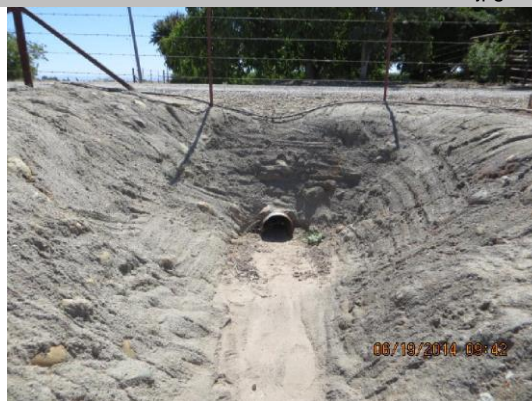
Photo 2 of 3 : UCIP_FA_2019_38646_70865.jpg

Pipe on WS slope.

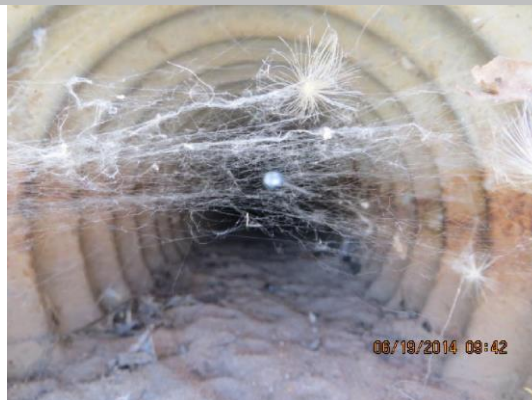
Photo 3 of 3 : UCIP_FA_2019_38646_70864.jpg

Inside pipe at WS toe.
