**Flood Control Project Maintenance
Levee Inspections**

Maintenance Issue Types Only, Levee Inspection Report By Mile - Fall 2019

San Joaquin County Flood Control and Water Conservation District

Waterway	Bank	Unit Miles	Inspection Start/End	Inspector
Unit No. 01 Littlejohn Creek	Left	2.59	11/14/2019 11/14/2019	Alberto De Leon

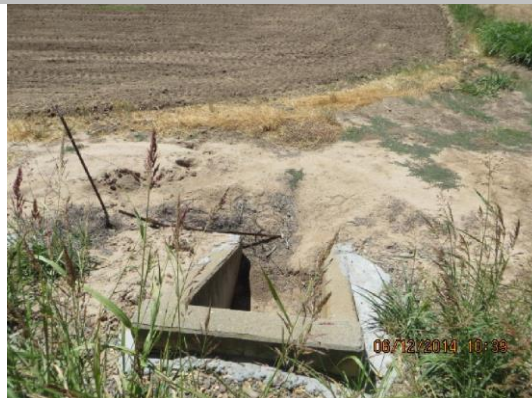
Photo 2 of 3 : UCIP_FA_2019_38578_70698.jpg

LM Start	0.03	Rating **	A/W	Issue No.	18 (cont)	
LM End	0.03	Issue Type +	Ma	Location *		
Category	Supplemental			GPS Latitude/Longitude		
				Start	End	
Item	DRAFT DWR UCIP LMA Responsibility			38.109370°	38.109370°	
				-121.159906°	-121.159906°	
DWR ID	23931					
Comment Code						
Inspector Comment						
DS_ID:23931						
FS_ID:38578						
EP_NO: N/A						
Repair Type: No Action Needed						
Crossing Status: Found						
UCIP Comments:						
FIELD_STRUCT_DESC: 24-inch corrugated metal drainage pipe						
through the levee, 5.5 feet below the crown. Concrete U-shaped						
headwall on both ends. Flap gate on the waterside (WS) end.						
[Additional Reference(s): DWR Levee Log, 1978. USACE San Joaquin						
O&M Manual 612.2, 1967, (HLM 0.03)].						
FS Date: 6/12/2014

Headwall at LS toe.

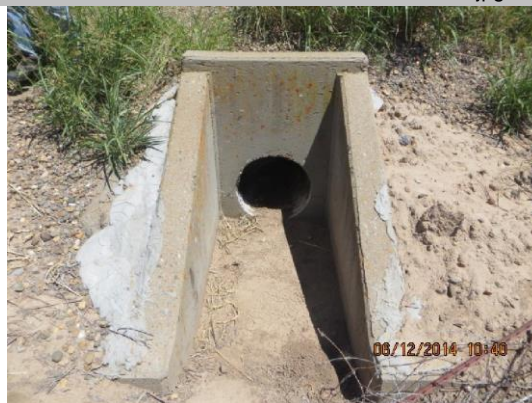
Photo 3 of 3 : UCIP_FA_2019_38578_70697.jpg

Headwall at LS toe.

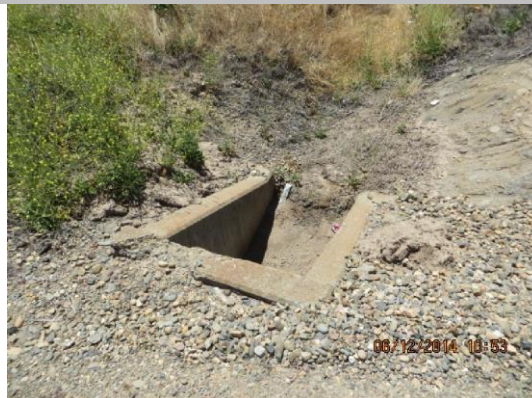
Photo 1 of 3 : UCIP_FA_2019_38581_70709.jpg

LM Start	0.55	Rating **	A/W	Issue No.	19
LM End	0.55	Issue Type +	Ma	Location *	
Category	Supplemental			GPS Latitude/Longitude	
				Start	End
Item	DRAFT DWR UCIP LMA Responsibility			38.110925 °	38.110925 °
				-121.150976 °	-121.150976 °
DWR ID	23933				
Comment Code					
Inspector Comment					
DS_ID:23933 FS_ID:38581 EP_NO: N/A Repair Type: No Action Needed Crossing Status: Found UCIP Comments: FIELD_STRUCT_DESC: 24-inch corrugated metal drainage pipe through the levee, 5 feet below the crown. Concrete U-shaped headwall on both ends. Flap gate on the waterside (WS) end. Cobble grouted spillway. Cobble grouted intake on the landside (LS). [Additional Reference(s): DWR Levee Log, 1978. USACE San Joaquin O&M Manual 612.2, 1967, (HLM 0.58)]. FS Date: 6/12/2014

Headwall at LS toe.

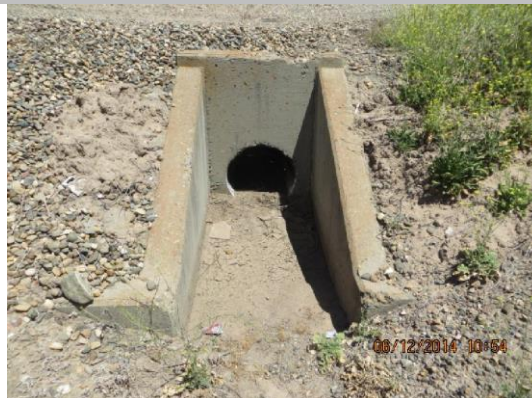
Photo 3 of 3 : UCIP_FA_2019_38581_70707.jpg

Headwall at LS toe.

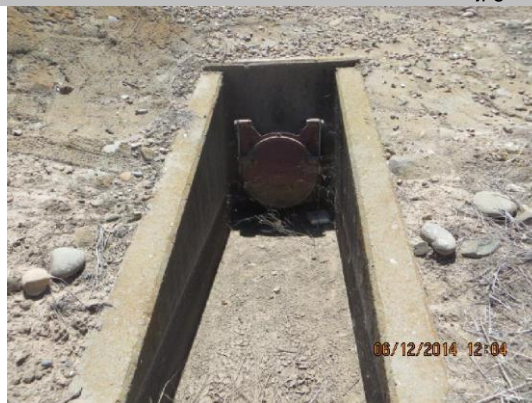
Photo 2 of 3 : UCIP_FA_2019_38582_70713.jpg

Headwall and flapgate on WS slope.

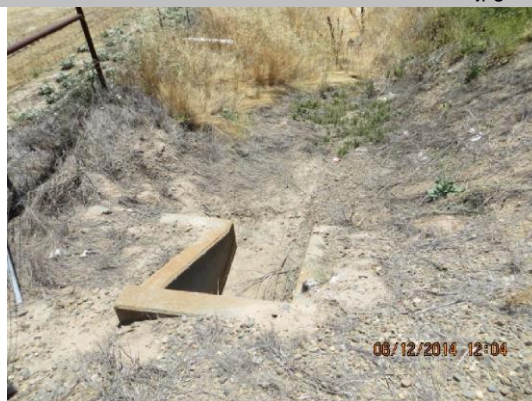
Photo 3 of 3 : UCIP_FA_2019_38582_70712.jpg

Headwall at LS toe.

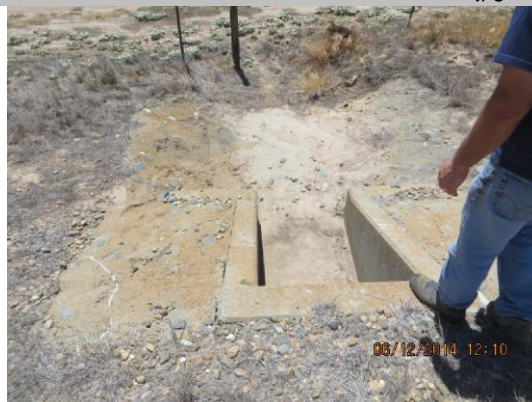
Photo 1 of 3 : UCIP_FA_2019_38583_70719.jpg

Headwall at LS toe.

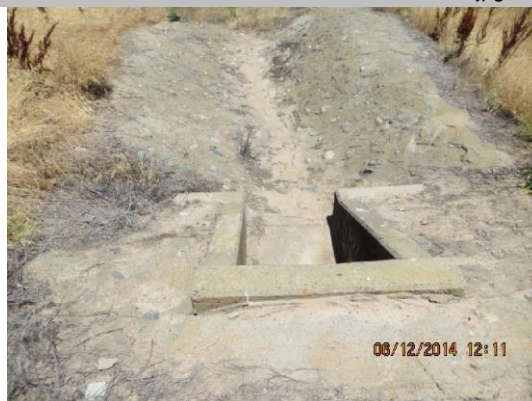
Photo 2 of 3 : UCIP_FA_2019_38583_70718.jpg

Headwall, flapgate, and grouted spillway on WS slope.

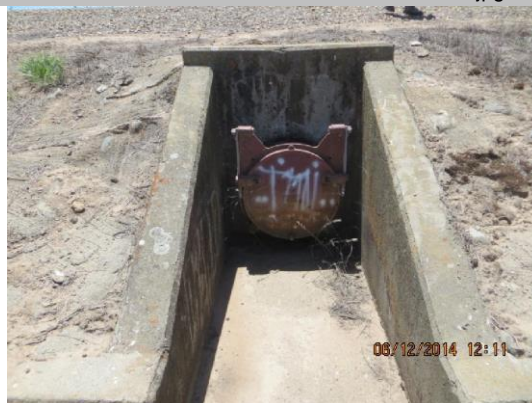
Photo 3 of 3 : UCIP_FA_2019_38583_70717.jpg

Headwall and flapgate on WS slope.

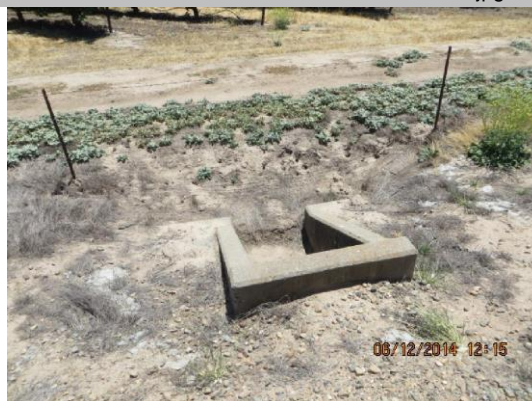
Photo 1 of 3 : UCIP_FA_2019_38585_70729.jpg

Headwall at LS toe.

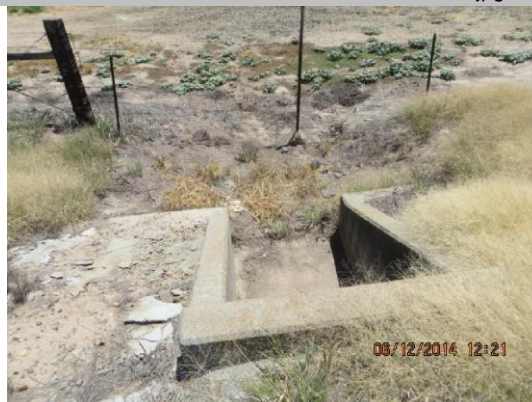
Photo 1 of 3 : UCIP_FA_2019_38586_70734.jpg

Headwall at LS toe.

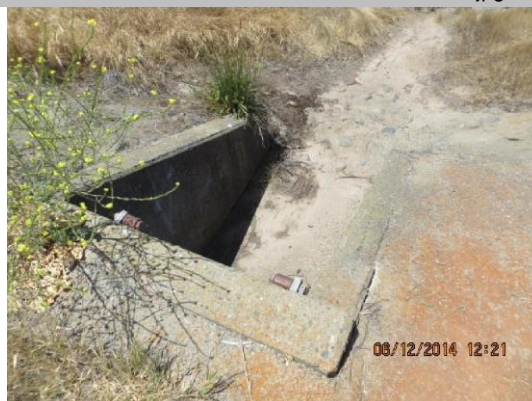
Photo 2 of 3 : UCIP_FA_2019_38586_70733.jpg

Headwall, flapgate, and grouted spillway on WS slope.

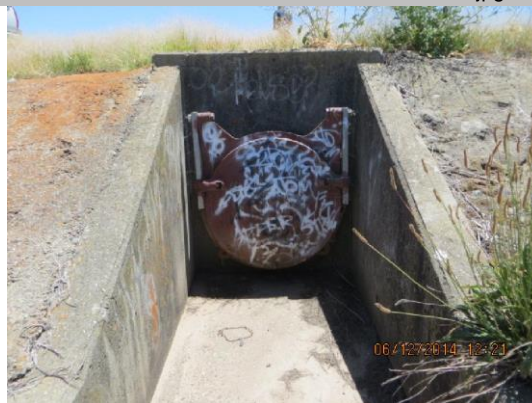
Photo 3 of 3 : UCIP_FA_2019_38586_70732.jpg

Headwall and flapgate on WS slope.

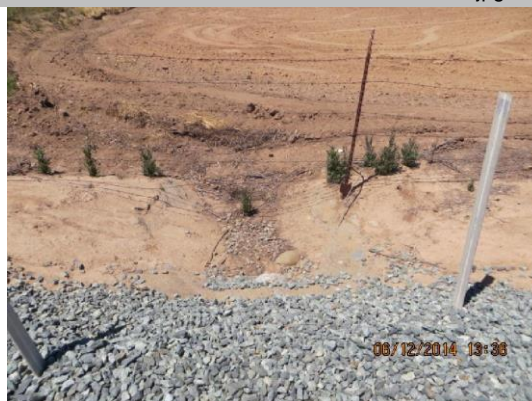
Photo 1 of 3 : UCIP_FA_2019_38623_70782.jpg

DS_ID:23939
FS_ID:38623
EP_NO: N/A
Repair Type: No Action Needed
Crossing Status: Found
UCIP Comments:
FIELD_STRUCT_DESC: 12-inch corrugated metal drainage pipe through the levee, 3 feet below the crown. Flap gate on the waterside (WS) end. Cobble grouted spillway. Cobble grouted intake on the landside (LS). [Additional Reference(s): DWR Levee Log, 1978. USACE San Joaquin O&M Manual 612.2, 1967, (HLM 0.02)].
FS Date: 6/12/2014 1:05:17 PM

Pipe at inlet on LS shoulder.

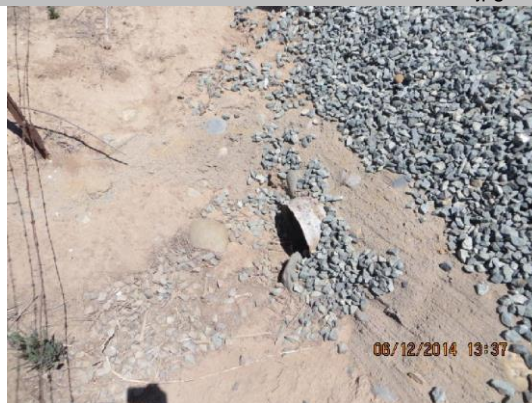
Photo 2 of 3 : UCIP_FA_2019_38623_70781.jpg

Pipe at inlet on LS shoulder.

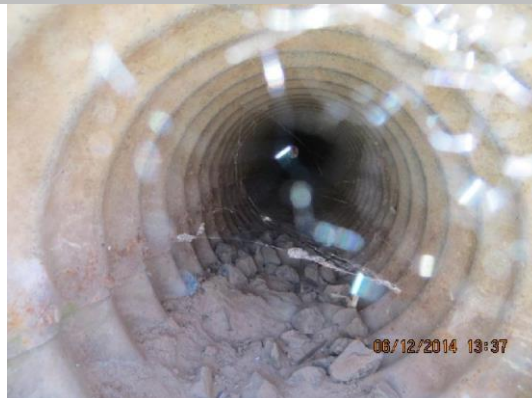
Photo 3 of 3 : UCIP_FA_2019_38623_70780.jpg

Inside pipe at LS toe.

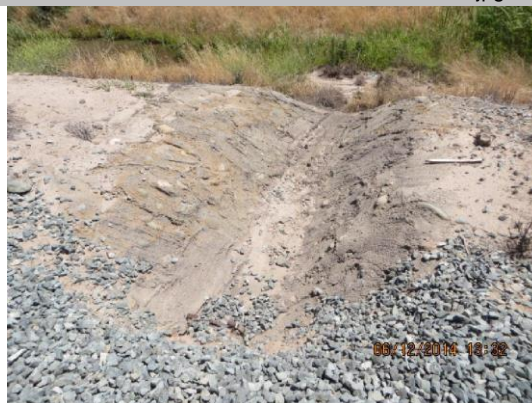
Photo 1 of 3 : UCIP_FA_2019_38615_70778.jpg

LM Start	0.25	Rating **	M	Issue No.	23	
LM End	0.25	Issue Type +	Ma	Location *		
Category	Supplemental			GPS Latitude/Longitude		
				Start	End	
Item	DRAFT DWR UCIP LMA Responsibility			38.109799 °	38.109799 °	
				-121.155621 °	-121.155621 °	
DWR ID	23940					
Comment Code						
Inspector Comment						
DS_ID:23940						
FS_ID:38615						
EP_NO: N/A						
Repair Type: Non-Urgent						
Crossing Status: Found						
UCIP Comments: Debris partially blocking closure of flapgate.						
FIELD_STRUCT_DESC: 12-inch corrugated metal drainage pipe through the levee, 3 feet below the crown. Flap gate on the waterside (WS) end. Cobble grouted spillway. [Additional Reference(s): DWR Levee Log, 1978. USACE San Joaquin O&M Manual 612.2, 1967, (HLM 0.25)].						
FS Date: 6/12/2014

Pipe, flapgate, and grouted spillway on WS slope.

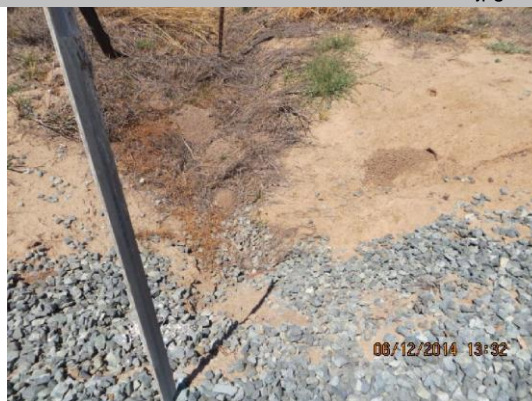
Photo 2 of 3 : UCIP_FA_2019_38615_70777.jpg

Pipe at inlet on LS shoulder.

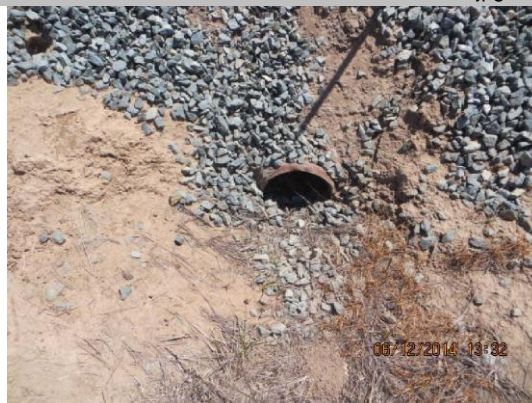
Photo 3 of 3 : UCIP_FA_2019_38615_70776.jpg

Pipe at inlet on LS shoulder.

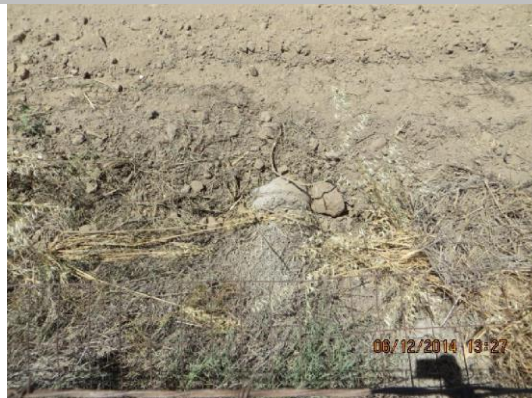
Photo 1 of 3 : UCIP_FA_2019_38614_70774.jpg

LM Start	0.37	Rating **	M	Issue No.	24	
LM End	0.37	Issue Type +	Ma	Location *		
Category	Supplemental			GPS Latitude/Longitude		
				Start	End	
Item	DRAFT DWR UCIP LMA Responsibility			38.109855 °	38.109855 °	
				-121.153390 °	-121.153390 °	
DWR ID	23941					
Comment Code						
Inspector Comment						
DS_ID:23941 FS_ID:38614 EP_NO: N/A Repair Type: Non-Urgent Crossing Status: Found UCIP Comments: Pipe buried on WS slope. FIELD_STRUCT_DESC: 12-inch corrugated metal drainage pipe through the levee, 1 foot below the crown. Flap gate on the waterside (WS) end. Cobble grouted spillway. [Additional Reference(s): DWR Levee Log, 1978. USACE San Joaquin O&M Manual 612.2, 1967, (HLM 0.38)]. FS Date: 6/12/2014

Pipe just visible on LS shoulder.

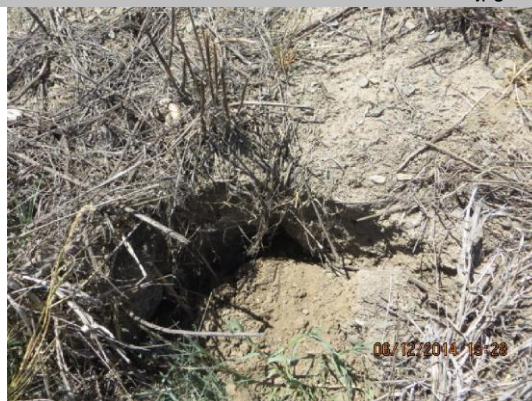
Photo 3 of 3 : UCIP_FA_2019_38614_70772.jpg

Pipe buried on WS slope.

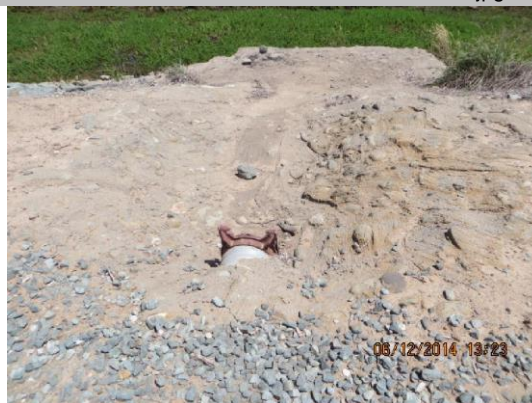
Photo 1 of 3 : UCIP_FA_2019_38613_70771.jpg

Flapgate, pipe, and grouted spillway on WS slope.

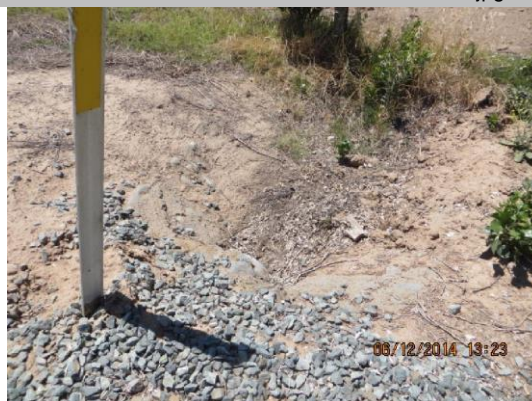
Photo 2 of 3 : UCIP_FA_2019_38613_70770.jpg

Inlet on LS shoulder.

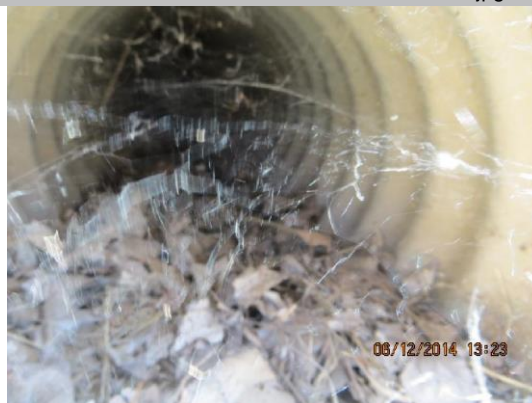
Photo 3 of 3 : UCIP_FA_2019_38613_70769.jpg

Inside pipe at LS shoulder.

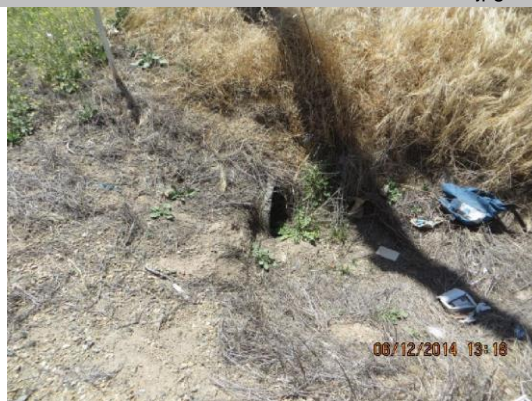
Photo 1 of 3 : UCIP_FA_2019_53502_70768.jpg

Comment Code						
Inspector Comment						
DS_ID:23943 FS_ID:53502 EP_NO: N/A Repair Type: Non-Urgent Crossing Status: Found UCIP Comments: 09/18/2018 Pipe is close to the crown. It may not create a serious situation. Maintenance required by owner at pipe inlet. Crossing downgraded to "Non-Urgent." (A. McDonald - DWR UCIP)11/04/2016 Same as previous inspection. Crossing remains Urgent crossing, open on both ends. (O. Magana - DWR UCIP)06/12/2014 Pipe inlet and outlet partially blocked by sediment. No flapgate. (W. Wylie - DWR UCIP) FIELD_STRUCT_DESC: 18-inch corrugated metal drainage pipe through the levee, 2.5 feet below the crown. Pipe open on both ends. Inlet is located at the end of a drainage ditch along the road. Cobble grouted spillway on the waterside (WS). [Additional Reference(s): DWR Levee Log, 1977, 1978, 1987, 1990. USACE San Joaquin O&M Manual Unit 612, Part No. 2 - Bear Creel Project, Unit 7: HLM 7.19 – 16.77, Unit 8: HLM 7.55-16.48, Unit 9: HLM 0.10-1.52; Unit 10: HLM 0.03-1.35, Unit 11: HLM 0.16-3.55, Unit 12: HLM 0.14-3.91; Unit 13, HLM 0.03-1.18; Unit 14, HLM 0.02-1.17, 1967, (HLM 0.55)]. FS Date: 9/18/2018

Pipe on LS toe.

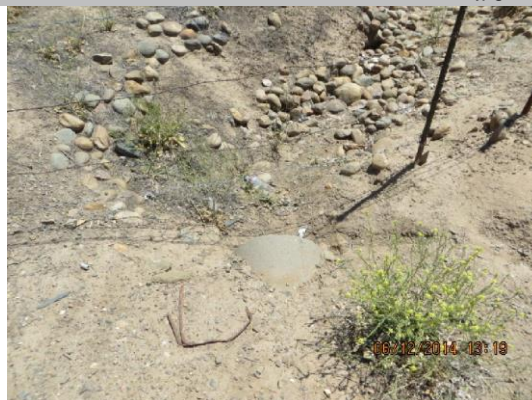
Photo 2 of 3 : UCIP_FA_2019_53502_70767.jpg

Pipe on WS shoulder.

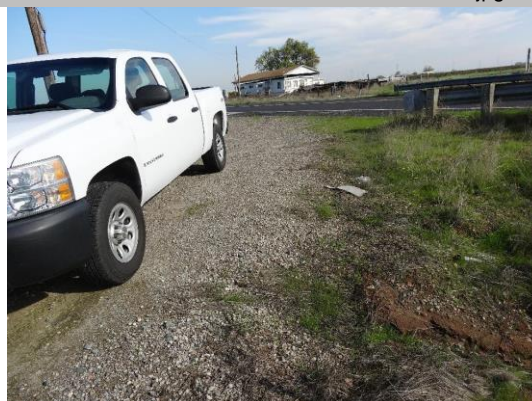
Photo 3 of 3 : UCIP_FA_2019_53502_76739.jpg

Comment Code						
Inspector Comment						
DS_ID:23943						
FS_ID:53502						
EP_NO: N/A						
Repair Type: Non-Urgent						
Crossing Status: Found						
UCIP Comments: 09/18/2018 Pipe is close to the crown. It may not create a serious situation. Maintenance required by owner at pipe inlet. Crossing downgraded to "Non-Urgent." (A. McDonald - DWR UCIP)11/04/2016 Same as previous inspection. Crossing remains Urgent crossing, open on both ends. (O. Magana - DWR UCIP)06/12/2014 Pipe inlet and outlet partially blocked by sediment. No flapgate. (W. Wylie - DWR UCIP)						
FIELD_STRUCT_DESC: 18-inch corrugated metal drainage pipe through the levee, 2.5 feet below the crown. Pipe open on both ends. Inlet is located at the end of a drainage ditch along the road. Cobble grouted spillway on the waterside (WS). [Additional Reference(s): DWR Levee Log, 1977, 1978, 1987, 1990. USACE San Joaquin O&M Manual Unit 612, Part No. 2 - Bear Creel Project, Unit 7: HLM 7.19 – 16.77, Unit 8: HLM 7.55-16.48, Unit 9: HLM 0.10-1.52; Unit 10: HLM 0.03-1.35, Unit 11: HLM 0.16-3.55, Unit 12: HLM 0.14-3.91; Unit 13, HLM 0.03-1.18; Unit 14, HLM 0.02-1.17, 1967, (HLM 0.55)].

Overview of levee crown at pipe crossing.

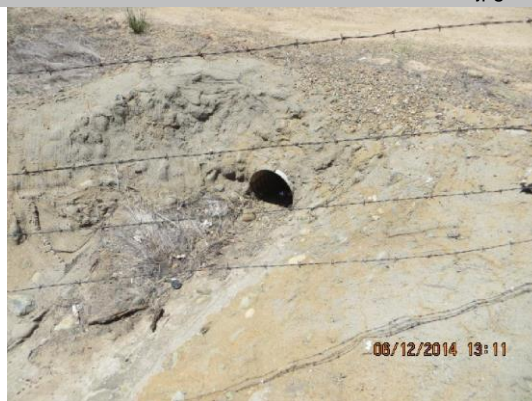
Photo 1 of 3 : UCIP_FA_2019_38610_70764.jpg

LM Start	0.56	Rating **	A/W	Issue No.	29
LM End	0.56	Issue Type +	Ma	Location *	
Category	Supplemental			GPS Latitude/Longitude	
				Start	End
Item	DRAFT DWR UCIP LMA Responsibility			38.111507°	38.111507°
				-121.150745°	-121.150745°
DWR ID	23944				
Comment Code					
Inspector Comment					
DS_ID:23944					
FS_ID:38610					
EP_NO: N/A					
Repair Type: No Action Needed					
Crossing Status: Found					
UCIP Comments:					
FIELD_STRUCT_DESC: 18-inch corrugated metal drainage pipe under the road, 2.5 feet below the crown. Open on both ends. Cobble grouted spillway. Cobble grouted intake on the landside (LS). [Additional Reference(s): DWR Levee Log, 1978. USACE San Joaquin O&M Manual 612.2, 1967, (HLM 0.57)].					
FS Date: 6/12/2014

Pipe and grouted spillway on WS

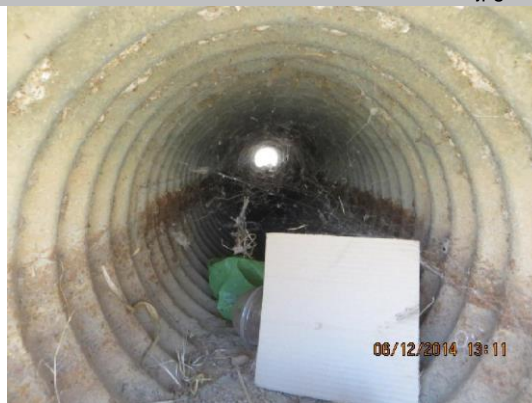
Photo 2 of 3 : UCIP_FA_2019_38610_70763.jpg

Inside pipe at LS toe.

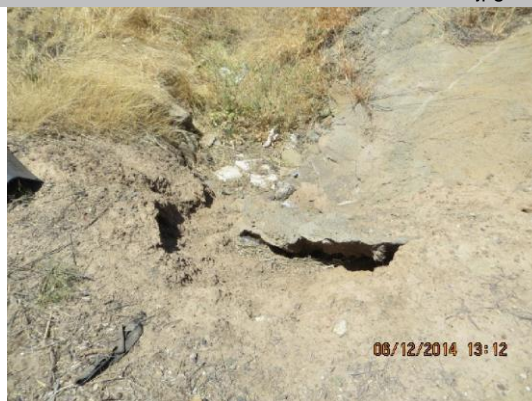
Photo 3 of 3 : UCIP_FA_2019_38610_70762.jpg

LM Start	0.56	Rating **	A/W	Issue No.	29 (cont)	
LM End	0.56	Issue Type +	Ma	Location *		
Category	Supplemental			GPS Latitude/Longitude		
				Start	End	
Item	DRAFT DWR UCIP LMA Responsibility			38.111507°	38.111507°	
				-121.150745°	-121.150745°	
DWR ID	23944					
Comment Code						
Inspector Comment						
DS_ID:23944						
FS_ID:38610						
EP_NO: N/A						
Repair Type: No Action Needed						
Crossing Status: Found						
UCIP Comments:						
FIELD_STRUCT_DESC: 18-inch corrugated metal drainage pipe under the road, 2.5 feet below the crown. Open on both ends. Cobble grouted spillway. Cobble grouted intake on the landside (LS). [Additional Reference(s): DWR Levee Log, 1978. USACE San Joaquin O&M Manual 612.2, 1967, (HLM 0.57)].						
FS Date: 6/12/2014

Pipe at LS toe.

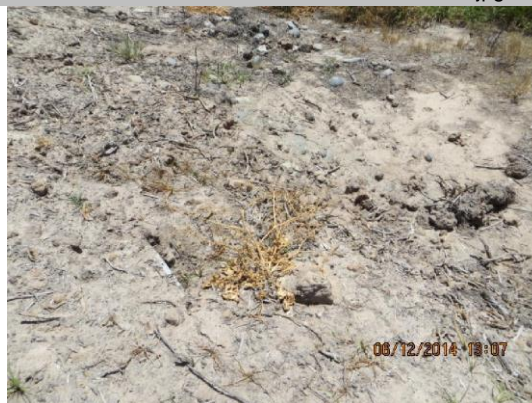
Photo 1 of 3 : UCIP_FA_2019_41365_70758.jpg

LM Start	0.75	Rating **	M	Issue No.	30
LM End	0.75	Issue Type +	Ma	Location *	
Category	Supplemental			GPS Latitude/Longitude	
				Start	End
Item	DRAFT DWR UCIP LMA Responsibility			38.111475 °	38.111475 °
				-121.148081 °	-121.148081 °
DWR ID	23945				
Comment Code					
Inspector Comment					
DS_ID:23945					
FS_ID:41365					
EP_NO: N/A					
Repair Type: Non-Urgent					
Crossing Status: Found					
UCIP Comments: Pipe open on both ends. Levee appears abandoned.					
FIELD_STRUCT_DESC: 24-inch corrugated metal drainage pipe through the levee, 1 foot below the crown. Cobble grouted spillway.					
Cobble grouted intake on the landside (LS). Open on both ends.					
[Additional Reference(s): DWR Levee Log, 1978. USACE San Joaquin O&M Manual 612.2, 1967, (HLM 0.76)].					
FS Date: 6/12/2014

Pipe on WS slope.

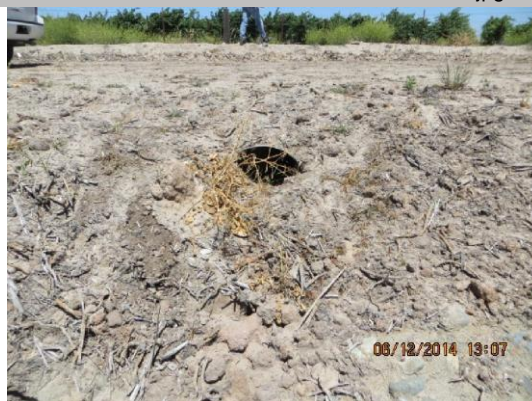
Photo 2 of 3 : UCIP_FA_2019_41365_70757.jpg

Pipe on WS slope.

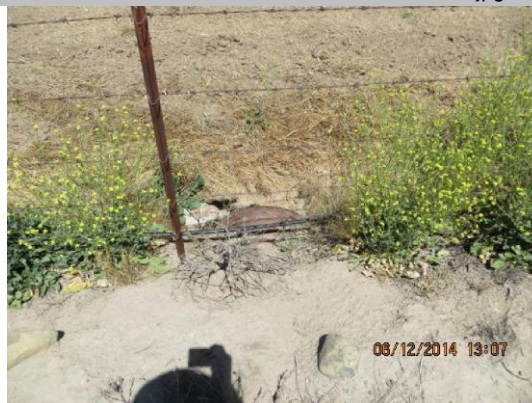
Photo 3 of 3 : UCIP_FA_2019_41365_70756.jpg

Pipe on LS shoulder.

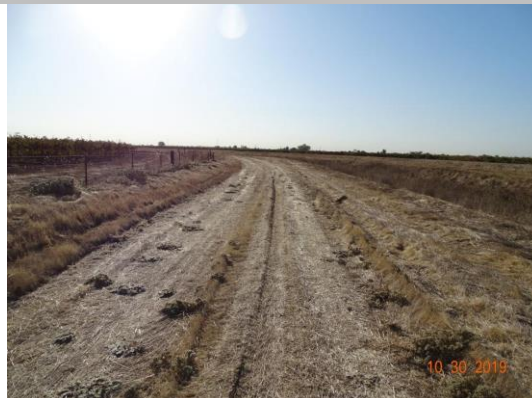
Photo 1 of 1 : FA_2019_NA0017_158_17_20191117_00045.jpg

LM Start	0.75	Rating **	M	Issue No.	17
LM End	0.75	Issue Type +	Ma	Location *	CR
Category	Earthen Levee			GPS Latitude/Longitude	
				Start	End
Item	Crown Surface / Depressions / Rutting			38.111370 °	38.111370 °
				-121.148009 °	-121.148009 °
DWR ID	DWR_NA0017_14_f_2019_17				
Comment Code					
C2 : Repair depressions or ruts in the crown or slope.					
Inspector Comment					
Ruts on crown surface caused by heavy equipment/farm tractor. LMA will regrade.

View of ruts on crown surface. Fall 2019

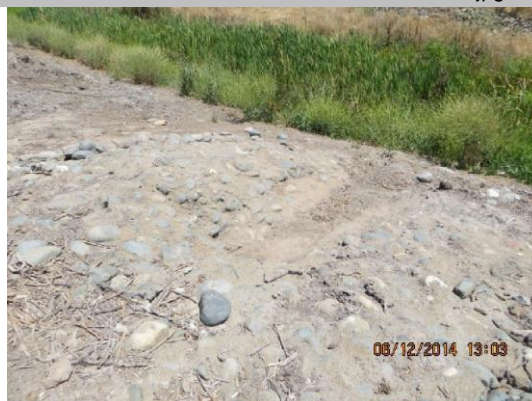
Photo 1 of 3 : UCIP_FA_2019_41791_70755.jpg

LM Start	0.94	Rating **	M	Issue No.	31
LM End	0.94	Issue Type +	Ma	Location *	
Category	Supplemental			GPS Latitude/Longitude	
				Start	End
Item	DRAFT DWR UCIP LMA Responsibility			38.110801 °	38.110801 °
				-121.145174 °	-121.145174 °
DWR ID	23946				
Comment Code					
Inspector Comment					
DS_ID:23946 FS_ID:41791 EP_NO: N/A Repair Type: Non-Urgent Crossing Status: Found UCIP Comments: Pipe burried on LS. Levee appears abandoned. FIELD_STRUCT_DESC: *ABANDONED* 12-inch corrugated metal drainage pipe through the levee, 2 feet below the crown. Open on both ends. Cobble grouted spillway. [Additional Reference(s): DWR Levee Log, 1978. USACE San Joaquin O&M Manual 612.2, 1967, (HLM 0.95)]. FS Date: 6/12/2014

Pipe and grouted spillway on WS slope.

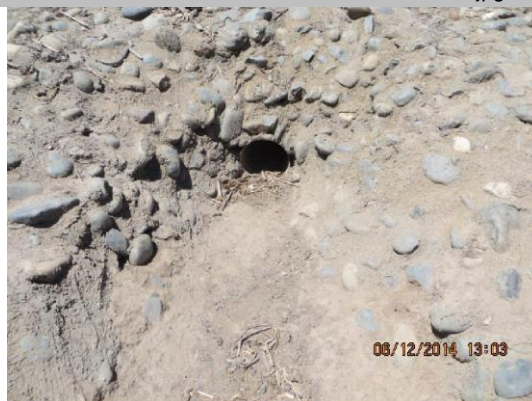
Photo 2 of 3 : UCIP_FA_2019_41791_70754.jpg

Pipe and grouted spillway on WS slope.

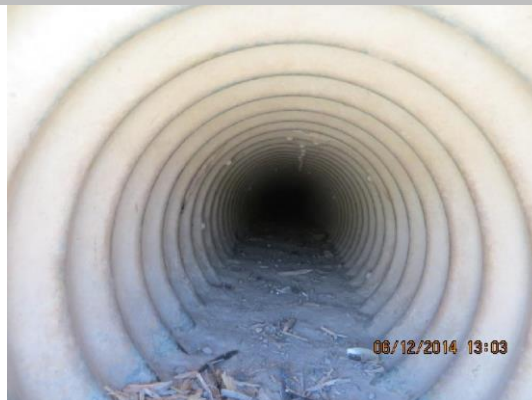
Photo 3 of 3 : UCIP_FA_2019_41791_70753.jpg

Inside pipe at WS slope.

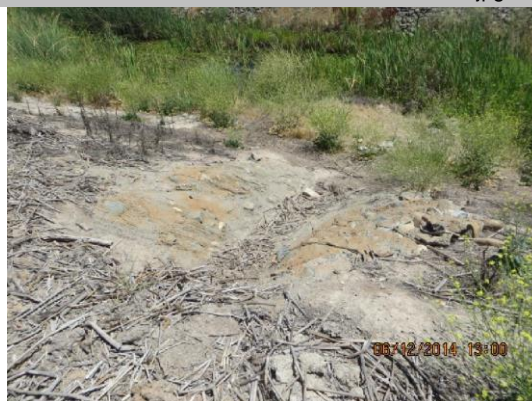
Photo 1 of 2 : UCIP_FA_2019_41792_70752.jpg

LM Start	0.96	Rating **	M	Issue No.	32
LM End	0.96	Issue Type +	Ma	Location *	
Category	Supplemental			GPS Latitude/Longitude	
				Start	End
Item	DRAFT DWR UCIP LMA Responsibility			38.110926°	38.110926°
				-121.144799°	-121.144799°
DWR ID	23947				
Comment Code					
Inspector Comment					
DS_ID:23947					
FS_ID:41792					
EP_NO: N/A					
Repair Type: Non-Urgent					
Crossing Status: Found					
UCIP Comments: Pipe burried on LS shoulder and open on WS.					
Levee appears abandoned.					
FIELD_STRUCT_DESC: *ABANDONED* 18-inch corrugated metal drainage pipe through the levee, 3 feet below the crown. Open on both ends. Cobble grouted spillway. Cobble grouted intake on the landside (LS). [Additional Reference(s): DWR Levee Log, 1978. USACE San Joaquin O&M Manual 612.2, 1967, (HLM 0.97)].					
FS Date: 6/12/2014

Pipe and grouted spillway on WS slope.

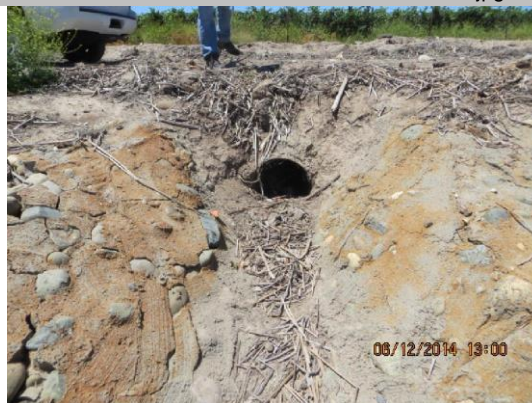
Photo 2 of 2 : UCIP_FA_2019_41792_70751.jpg

Pipe and grouted spillway on WS slope.

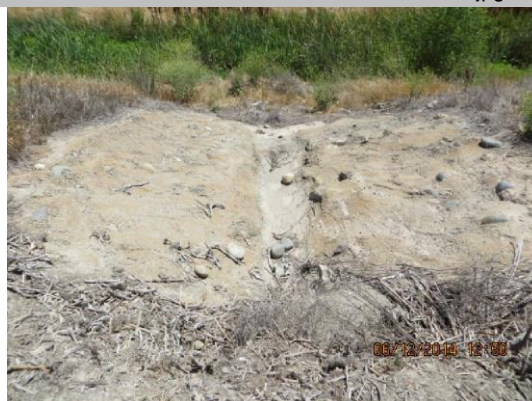
Photo 3 of 3 : UCIP_FA_2019_41793_70744.jpg

LM Start	1.11	Rating **	M	Issue No.	34 (cont)	
LM End	1.11	Issue Type +	Ma	Location *		
Category	Supplemental			GPS Latitude/Longitude		
				Start		End
Item	DRAFT DWR UCIP LMA Responsibility			38.112125 °		38.112125 °
				-121.142568 °		-121.142568 °
DWR ID	23949					
Comment Code						
Inspector Comment						
DS_ID:23949 FS_ID:41793 EP_NO: N/A Repair Type: Non-Urgent Crossing Status: Found UCIP Comments: Pipe appears abandoned. Levee appears Abandoned. FIELD_STRUCT_DESC: *ABANDONED* 12-inch corrugated metal drainage pipe through the levee, 2.5 feet below the crown. Flap gate on the waterside (WS) end. Cobble grouted spillway. Cobble grouted intake on the landside (LS). [Additional Reference(s): DWR Levee Log, 1978. USACE San Joaquin O&M Manual 612.2, 1967, (HLM 1.12)]. FS Date: 6/12/2014

Pipe, flapgate, and grouted spillway on WS slope.

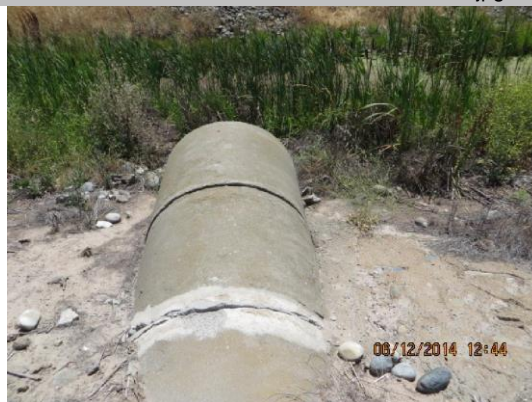
Photo 1 of 3 : UCIP_FA_2019_41794_70742.jpg

LM Start	1.16	Rating **	M	Issue No.	35
LM End	1.16	Issue Type +	Ma	Location *	
Category	Supplemental			GPS Latitude/Longitude	
				Start	End
Item	DRAFT DWR UCIP LMA Responsibility			38.112296 °	38.112296 °
				-121.141654 °	-121.141654 °
DWR ID	23950				
Comment Code					
Inspector Comment					
DS_ID:23950					
FS_ID:41794					
EP_NO: N/A					
Repair Type: Non-Urgent					
Crossing Status: Found					
UCIP Comments: Pipe open on both ends. Levee appears abandoned.					
FIELD_STRUCT_DESC: 48-inch reinforced concrete drainage pipe through the levee, 5.5 feet below the crown. Cobble grouted spillway.					
Cobble grouted intake on the landside (LS). Open on both ends.					
[Additional Reference(s): DWR Levee Log, 1978. USACE San Joaquin O&M Manual 612.2, 1967, (HLM 1.17)].					
FS Date: 6/12/2014

Pipe on WS toe.

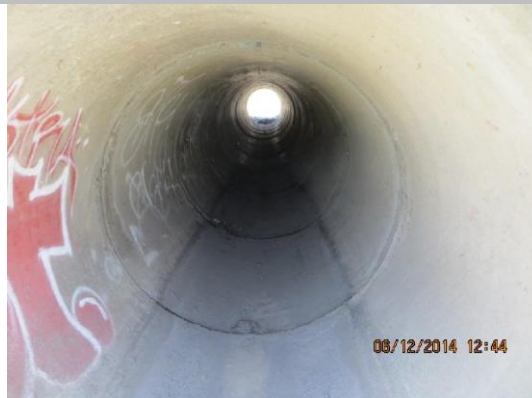
Photo 2 of 3 : UCIP_FA_2019_41794_70741.jpg

Inside pipe.

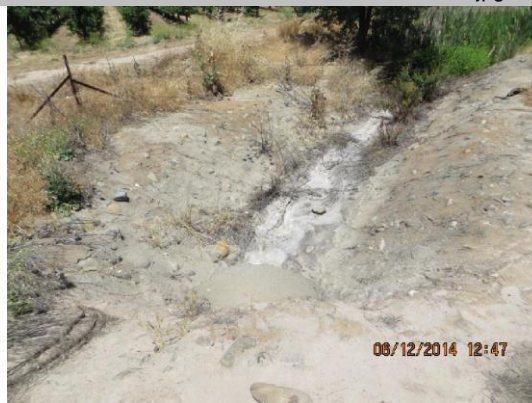
Photo 3 of 3 : UCIP_FA_2019_41794_70740.jpg

Pipe at LS intake.

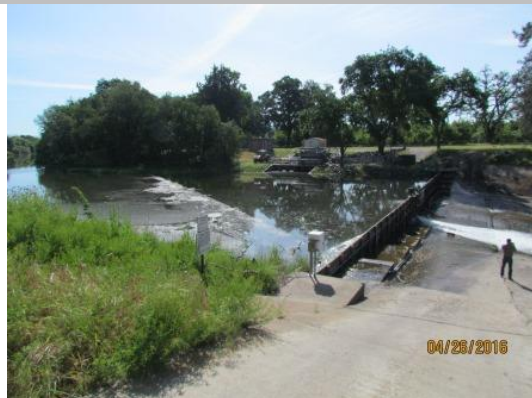
Photo 1 of 1 : FA_2019_NA0017_159_1155_20190830_00130.jpg

LM Start	0.00	Rating **	A/W	Issue No.	1155
LM End	0.00	Issue Type +	Ma	Location *	WS
Category	Interior Drainage & Piping Systems			GPS Latitude/Longitude	
				Start	End
Item	Vegetation & Obstructions			0.000000 °	0.000000 °
				0.000000 °	0.000000 °
DWR ID	DWR_NA0017_15_s_2014_1155				
Comment Code					
Inspector Comment					
This is the Upper Calaveras river channel. No levee exists.

View of the dam at the starting of the Mormon slough.

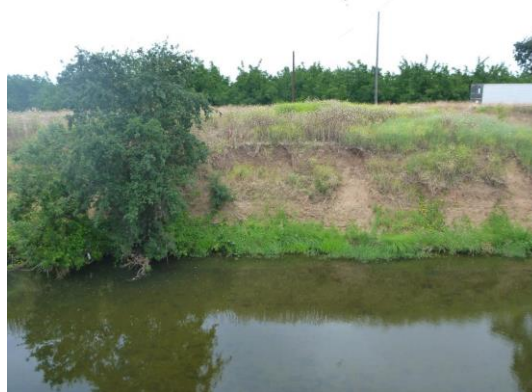
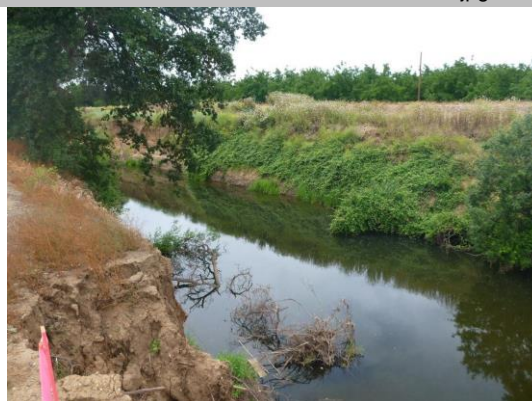
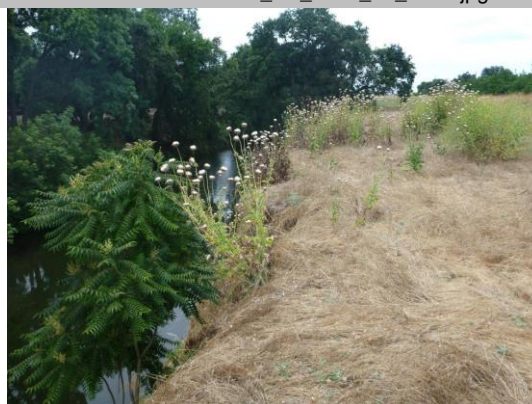
LM Start	0.26	Rating **	A/W	Issue No.	155
LM End	1.06	Issue Type +	Ma	Location *	WS
Category	Supplemental			GPS Latitude/Longitude	
				Start	End
Item	2017 Storm Damage			38.049780 °	38.043090 °
				-121.014681 °	-121.026200 °
DWR ID	DWR_NA0017_15_s_2012_10				
Comment Code					
Inspector Comment					
Levee Evaluation Comments					
Description:					
Site ID No:83					
Site Designation:DWR_NA0017_15_s_2012_10					
Repair Type: Erosion					
Rating:Area of Concern					
Field Date:6/7/2017					
Notes: Channel incising is cutting near vertical slopes almost 20' high. Bank along site has between 30' to 10' remaining. This site is currently under contract for repair by FSRP.

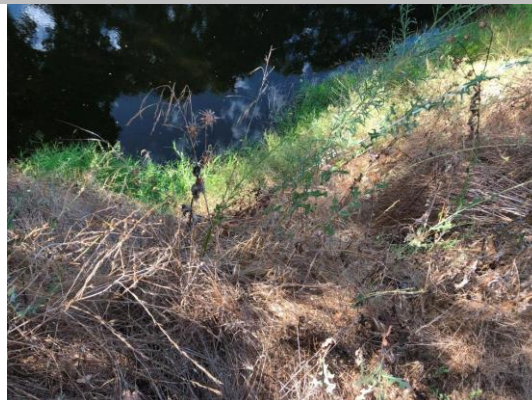
Photo 1 of 3 : SJR2019_NA0017U15RM22.91_2.jpg

Site ID: NA0017U15RM22.91
 08/28/2019: No significant change observed. This area is patrol road only.
 08/30/2017: No significant change observed.
 08/16/2016: No significant change observed.
 08/12/2015: No significant change observed.
 08/20/2014: No significant change has been observed.
 09/12/2013: No significant change observed.
 08/22/2012: Site has been revisited. No significant change observed.
 09/02/2011: No significant change observed on site.
 11/02/2010: No significant change observed. The mile-long erosion continues to degrade the bank. There are a few trees along the mile-long stretch on the lower bank slope that are affected by the scarp. WS Levee Slope was changed to 2:1. As a result, normalized score increased from 62 to 65.
 08/05/2010: Recommended for waterside repair, per CLRO; "water velocity is a major factor for accelerating bank slope erosion."
 8/12/2009: Near-vertical bank erosion; degrading channel is incising the banks; recommend annual assessment and monitoring of critical erosion site, per CLRO CES Evaluation 2008 Report; district is monitoring site for change in condition; site was previously rated "U".

Looking at the site from the levee top.

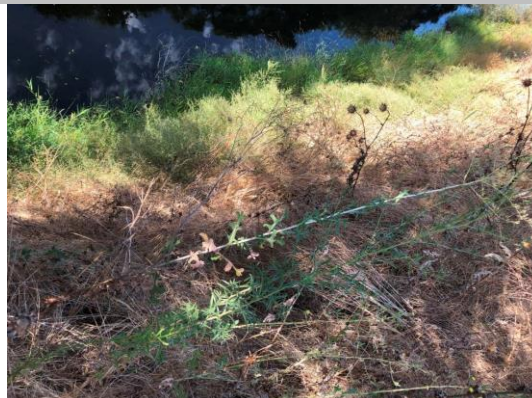
Photo 2 of 3 : SJR2019_NA0017U15RM22.91_5.jpg

Close-up view of the erosion. Note dense vegetation and trees on site.

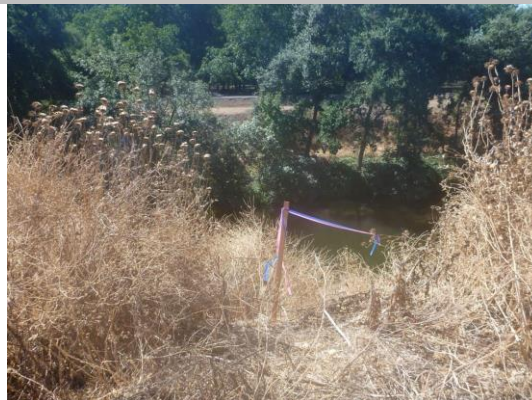
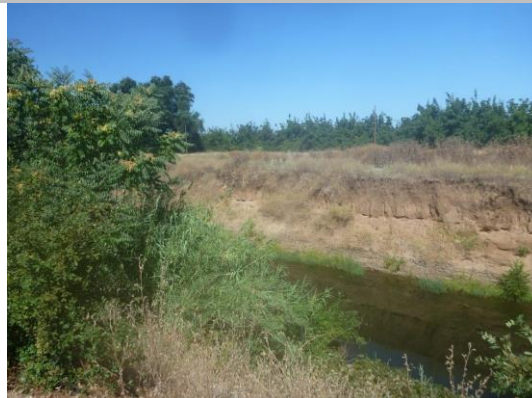
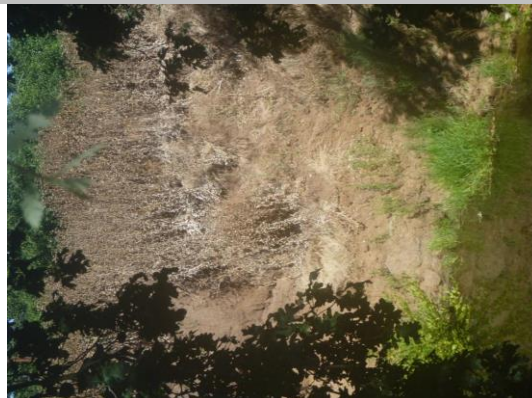
Notes: The erosion is pretty severe, but rated it serious because left bank is quite a bit lower and actual levee is pretty small. RD rep said water did not get up to monitor stage last year. Under FSRP Repair?

LM Start	0.79	Rating **	A/W	Issue No.	156 (cont)	
LM End		Issue Type +	Ma	Location *	WS	
Category	Supplemental			GPS Latitude/Longitude		
				Start	End	
Item	2017 Storm Damage			38.045930 °	38.045341 °	
				-121.023021 °	-121.034014 °	
DWR ID	LMA-304					
Comment Code						
Inspector Comment						
Levee Evaluation Comments						
Description:Erosion along the right bank of the waterside slope. Erosion extends approximately 354'.						
Site ID No:477						
Site Designation:LMA-304						
Repair Type: Erosion						
Rating:Critical						
Field Date:7/27/2017						
Notes: The erosion is pretty severe, but rated it serious because left bank is quite a bit lower and actual levee is pretty small. RD rep said water did not get up to monitor stage last year. Under FSRP Repair?

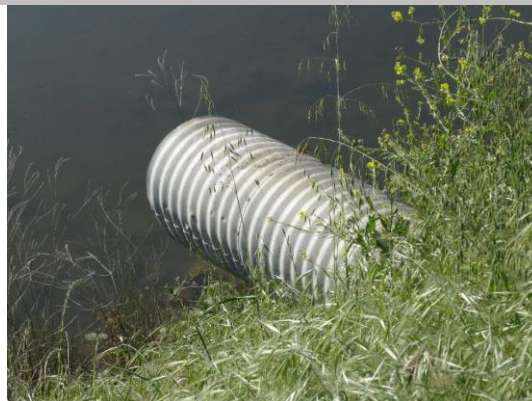
Photo 1 of 2 : UCIP_FA_2019_34877_62779.jpg

LM Start	1.16	Rating **	M	Issue No.	1158	
LM End	1.16	Issue Type +	Ma	Location *		
Category	Supplemental			GPS Latitude/Longitude		
				Start		End
Item	DRAFT DWR UCIP LMA Responsibility			38.041907 °		38.041907 °
				-121.027235 °		-121.027235 °
DWR ID	23199					
Comment Code						
Inspector Comment						
DS_ID:23199 FS_ID:34877 EP_NO: N/A Repair Type: Non-Urgent Crossing Status: Found UCIP Comments: Deformed inlet opening. Needs cleaning and clearing on inlet opening on landside. FIELD_STRUCT_DESC: 18-inch corrugated metal drainage pipe through the levee, 4.5 feet below the crown. Grouted spillway on the waterside (WS) end. Open on both ends. [Additional Reference(s): DWR Levee Log, 1992. USACE San Joaquin O&M Manual 611.1, Volume F, (HLM 1.18)]. FS Date: 4/9/2014

WS view: CM outfall pipe on channel bank.

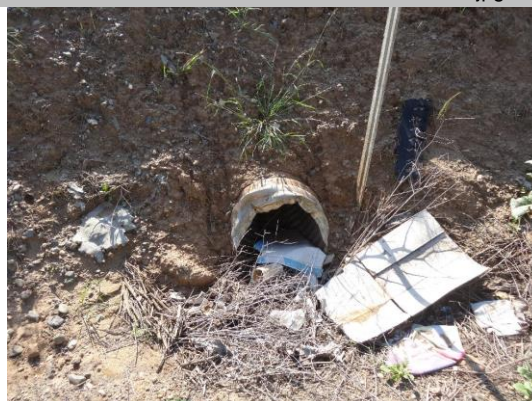
Photo 2 of 2 : UCIP_FA_2019_34877_62778.jpg

LM Start	1.16	Rating **	M	Issue No.	1158 (cont)	
LM End	1.16	Issue Type +	Ma	Location *		
Category	Supplemental			GPS Latitude/Longitude		
				Start	End	
Item	DRAFT DWR UCIP LMA Responsibility			38.041907 °	38.041907 °	
				-121.027235 °	-121.027235 °	
DWR ID	23199					
Comment Code						
Inspector Comment						
DS_ID:23199						
FS_ID:34877						
EP_NO: N/A						
Repair Type: Non-Urgent						
Crossing Status: Found						
UCIP Comments: Deformed inlet opening. Needs cleaning and clearing on inlet opening on landside.						
FIELD_STRUCT_DESC: 18-inch corrugated metal drainage pipe through the levee, 4.5 feet below the crown. Grouted spillway on the waterside (WS) end. Open on both ends. [Additional Reference(s): DWR Levee Log, 1992. USACE San Joaquin O&M Manual 611.1, Volume F, (HLM 1.18)].						
FS Date: 4/9/2014

LS view: CM inlet pipe. Pipe opening obstructed with debris.

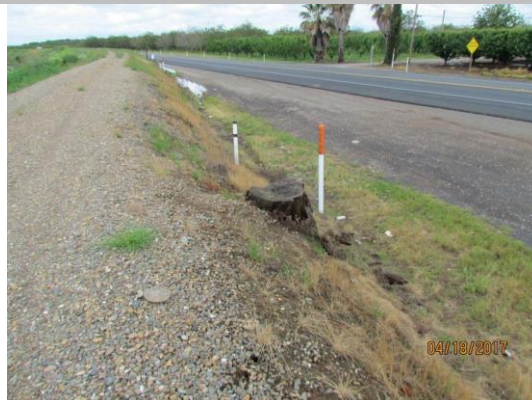
Photo 1 of 1 : FA_2019_NA0017_159_1128_20190830_00129.jpg

LM Start	1.45	Rating **	N	Issue No.	1128
LM End	1.45	Issue Type +	Ma	Location *	LS
Category	Earthen Levee			GPS Latitude/Longitude	
				Start	End
Item	Trim / Thin Trees			38.040188°	38.040188°
				-121.031854°	-121.031854°
DWR ID	DWR_NA0017_15_s_2012_1128				
Comment Code					
T5 : Tree stumps.					
Inspector Comment

View of a tree stump on the landside shoulder of the levee.

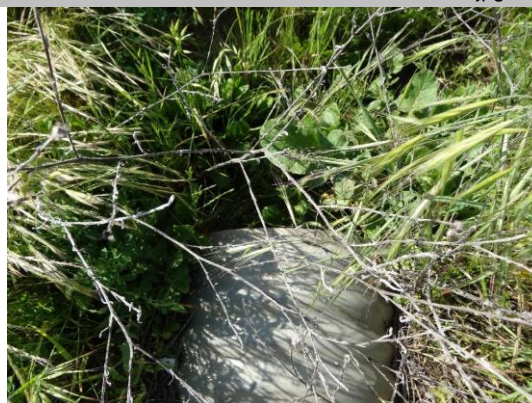
Photo 1 of 3 : UCIP_FA_2019_40369_62785.jpg

WS view: outlet CM pipe on levee slope.

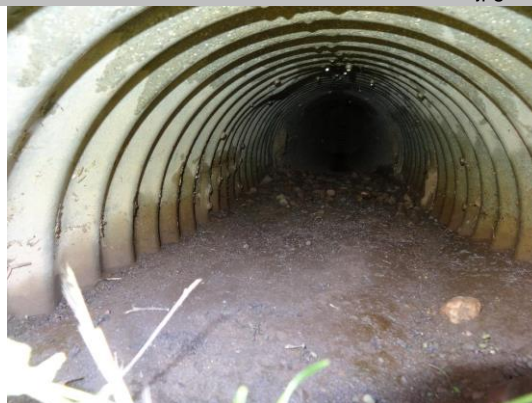
Photo 2 of 3 : UCIP_FA_2019_40369_62784.jpg

WS view: inside view of the outlet pipe. Needs cleaning and clearing.

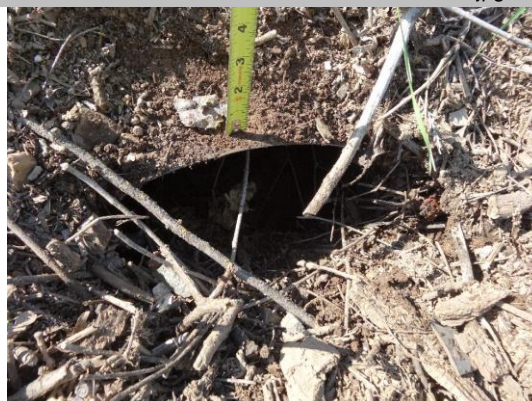
Photo 3 of 3 : UCIP_FA_2019_40369_62783.jpg

LS view: buried inlet pipe. Needs cleaning and clearing.

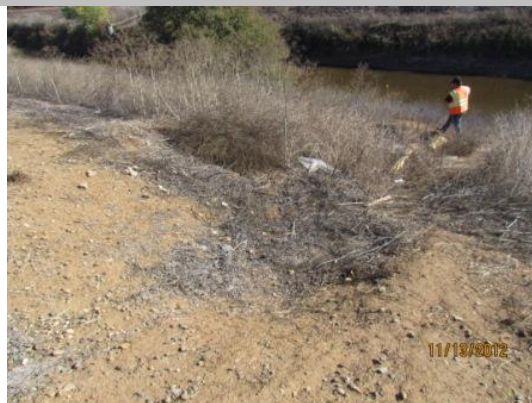
Photo 1 of 2 : FA_2019_NA0017_159_18_20190830_00023.jpg

LM Start	2.05	Rating **	M	Issue No.	18
LM End	2.05	Issue Type +	Ma	Location *	WS
Category	Earthen Levee			GPS Latitude/Longitude	
				Start	End
Item	Slope Stability			38.036294°	38.036294°
				-121.041089°	-121.041089°
DWR ID	DWR_NA0017_15_f_2019_18				
Comment Code					
S1 : Repair slope instability.					
Inspector Comment

Picture of the slope instability at the waterside slope of the levee looking upstream.

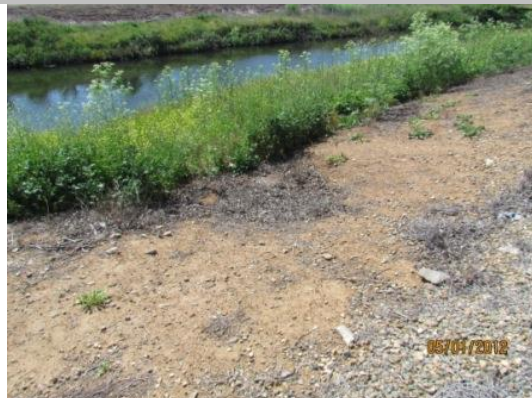
Photo 2 of 2 : FA_2019_NA0017_159_18_20190830_00024.jpg

LM Start	2.05	Rating **	M	Issue No.	18 (cont)	
LM End	2.05	Issue Type +	Ma	Location *	WS	
Category	Earthen Levee			GPS Latitude/Longitude		
				Start		End
Item	Slope Stability			38.036294 °		38.036294 °
				-121.041089 °		-121.041089 °
DWR ID	DWR_NA0017_15_f_2019_18					
Comment Code						
S1 : Repair slope instability.						
Inspector Comment

Slope instability was found on the waterside toe of the levee looking downstream.

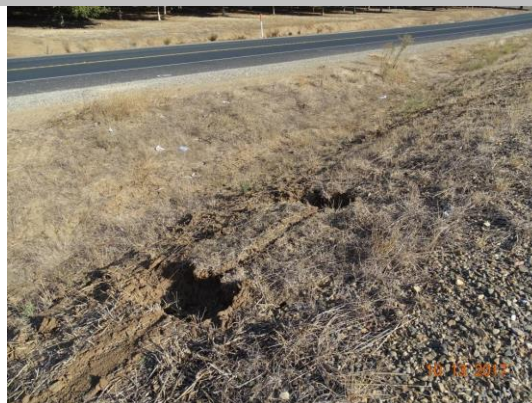
Photo 1 of 1 : FA_2019_NA0017_159_159_20190830_00083.jpg

LM Start	2.30	Rating **	M	Issue No.	159
LM End	2.30	Issue Type +	Ma	Location *	LS
Category	Earthen Levee			GPS Latitude/Longitude	
				Start	End
Item	Slope Stability			38.033687 °	38.033687 °
				-121.044156 °	-121.044156 °
DWR ID	DWR_NA0017_15_f_2017_159				
Comment Code					
S3 : Repair the levee slope damaged by vehicle traffic and prevent access where possible.					
Inspector Comment

View of a slope instability on the landside of the levee looking upstream.
Fall 2017

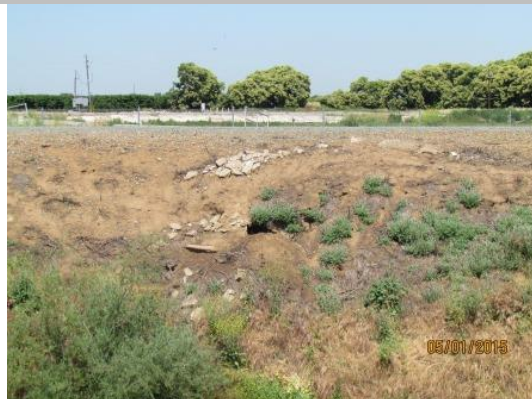
Photo 1 of 1 : FA_2019_NA0017_159_208_20190830_00108.jpg

LM Start	3.77	Rating **	U	Issue No.	208
LM End	3.77	Issue Type +	Ma	Location *	WS
Category	Earthen Levee			GPS Latitude/Longitude	
				Start	End
Item	Animal Control			38.019253 °	38.019253 °
				-121.063867 °	-121.063867 °
DWR ID	DWR_NA0017_15_s_2015_208				
Comment Code					
A3 : No rodents visible, but rodent burrows visible; need to backfill and compact or grout burrows.					
Inspector Comment

A rodent hole was found on the waterside of the levee. The picture was taken from the opposite side of the levee.

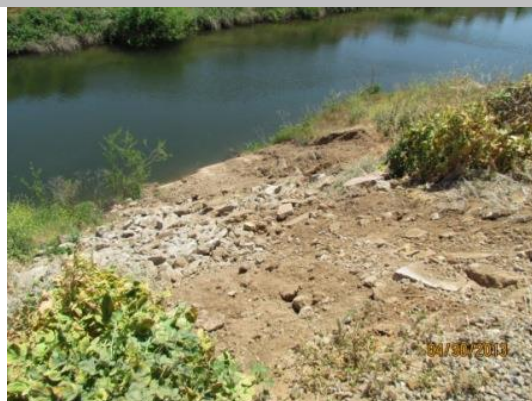
Photo 1 of 2 : FA_2019_NA0017_159_43_20190830_00031.jpg

LM Start	3.78	Rating **	M	Issue No.	43
LM End	3.78	Issue Type +	Ma	Location *	WS
Category	Earthen Levee			GPS Latitude/Longitude	
				Start	End
Item	Slope Stability			38.019119°	38.019119°
				-121.064034°	-121.064034°
DWR ID	DWR_NA0017_15_f_2012_43				
Comment Code					
S1 : Repair slope instability.					
Inspector Comment

Picture of the slope instability on the waterside slope of the levee looking downstream.

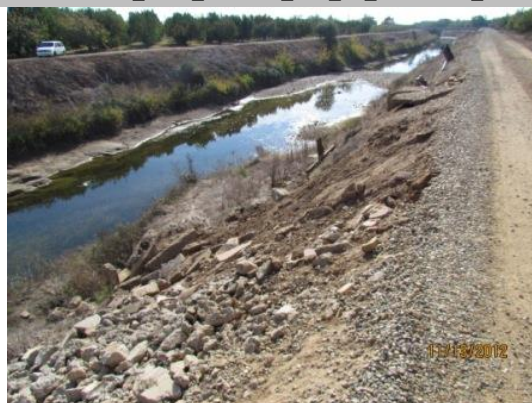
Photo 2 of 2 : FA_2019_NA0017_159_43_20190830_00032.jpg

Slope instability was found on the waterside slope of the levee looking downstream.

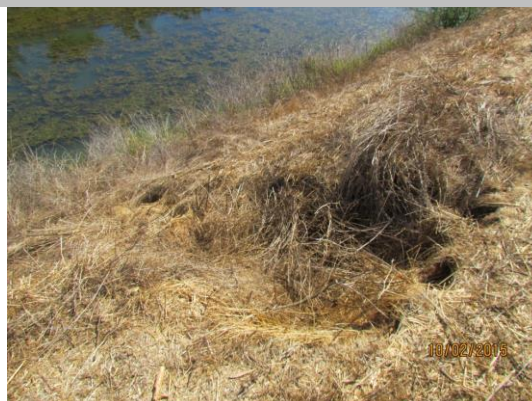
Photo 2 of 2 : FA_2019_NA0017_159_133_20190830_00065.jpg

LM Start	4.51	Rating **	M	Issue No.	133 (cont)	
LM End	4.51	Issue Type +	Ma	Location *	WS	
Category	Earthen Levee			GPS Latitude/Longitude		
				Start		End
Item	Erosion / Bank Caving			38.009753 °		38.009753 °
				-121.069559 °		-121.069559 °
DWR ID	DWR_NA0017_15_f_2015_133					
Comment Code						
E2 : Schedule repair of erosion site prior to the next inspection.						
Inspector Comment

Erosion was found on the waterside shoulder of the levee looking downstream.

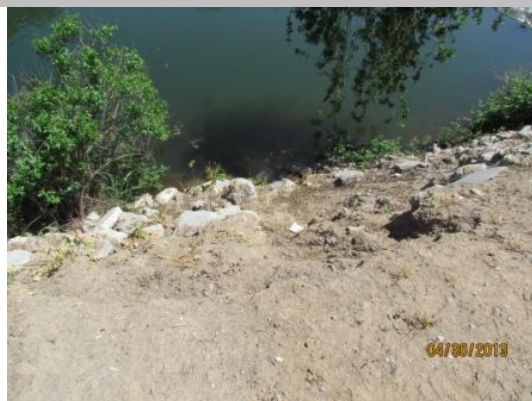
Photo 1 of 1 : FA_2019_NA0017_159_96_20190830_00055.jpg

LM Start	4.63	Rating **	A/W	Issue No.	96
LM End	4.63	Issue Type +	Ma	Location *	WS
Category	Earthen Levee			GPS Latitude/Longitude	
				Start	End
Item	Erosion / Bank Caving			38.008053 °	38.008053 °
				-121.070141 °	-121.070141 °
DWR ID	DWR_NA0017_15_s_2012_96				
Comment Code					
E1 : Note and monitor erosion site.					
Inspector Comment					
LMA has fixed the issue but the riprap has rebar which can be dangerous during a flood fighting effort.

Picture of the slope instability on the waterside slope of the levee looking downstream during spring 2013 inspection.

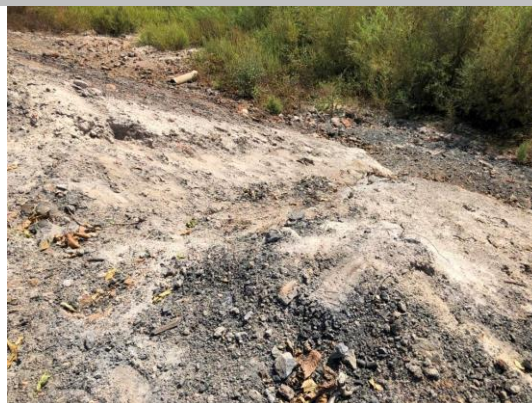
Photo 1 of 2 : SJR2019_DWR_NA0017_15_s_2017_242_1.JPG

LM Start	4.86	Rating **	U	Issue No.	4
LM End	4.86	Issue Type +	Ma	Location *	
Category	Supplemental			GPS Latitude/Longitude	
				Start	End
Item	DWR Erosion Survey			38.005099 °	38.005099 °
				-121.071910 °	-121.071910 °
DWR ID	NA0017U15RM18.1				
Comment Code					
Inspector Comment					
Site ID: NA0017U15RM18.1 08/28/2019: The original erosion has been repaired with placed loose material, but the site still shows significant erosion approximately 4-ft (W) X 20-ft (H). The erosion was caused by rainfall runoff.

Looking down at the erosion from the bank top.

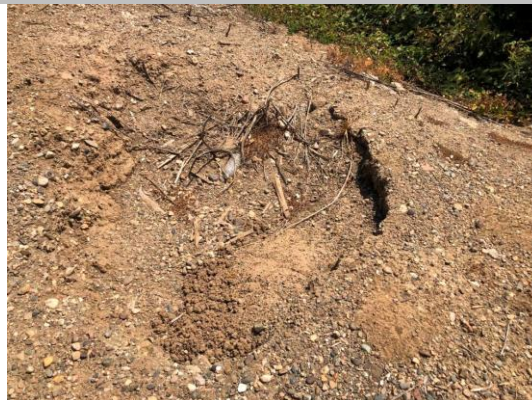
Photo 2 of 2 : SJR2019_DWR_NA0017_15_f _ 2017_161_2.jpg

LM Start	5.43	Rating **	A/W	Issue No.	140 (cont)	
LM End	5.43	Issue Type +	Ma	Location *		
Category	Supplemental			GPS Latitude/Longitude		
				Start	End	
Item	DWR Erosion Survey			37.998297 °	37.998297 °	
				-121.077821 °	-121.077821 °	
DWR ID	NA0017U15RM17.84					
Comment Code						
Inspector Comment						
Site ID: NA0017U15RM17.84						
08/28/2019: The erosion is located at the levee shoulder, and was caused by rainfall runoff. There does not appear to be a levee at this location, patrol road only.

Close-up view of the erosion.

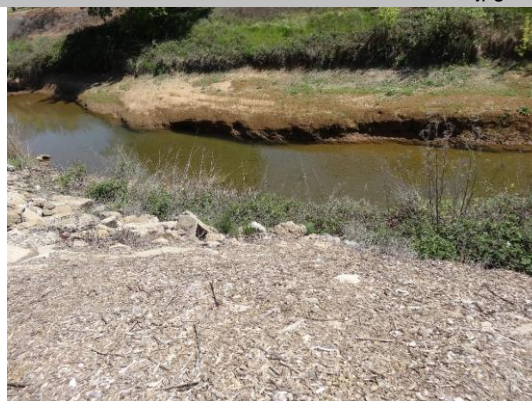
Photo 1 of 2 : UCIP_FA_2019_34924_62867.jpg

WS view: no pipe and structure found on waterside. Dense vegetation on channel bank.

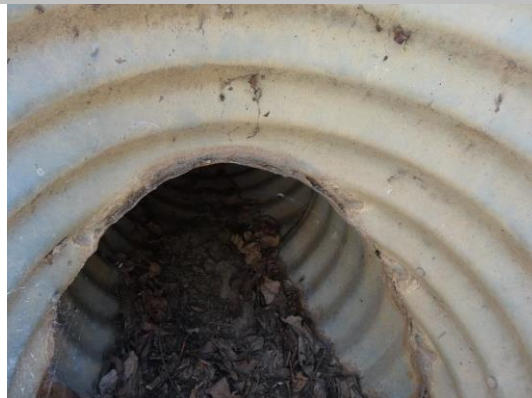
Photo 2 of 2 : UCIP_FA_2019_34924_62866.jpg

LS view: inside view of CMP inlet chamber.
