**Flood Control Project Maintenance
Levee Inspections**

Maintenance Issue Types Only, Levee Inspection Report By Mile - Fall 2019

San Joaquin County Flood Control and Water Conservation District

Waterway	Bank	Unit Miles	Inspection Start/End	Inspector
Unit No. 01 Littlejohn Creek	Left	2.59	11/14/2019 11/14/2019	Alberto De Leon

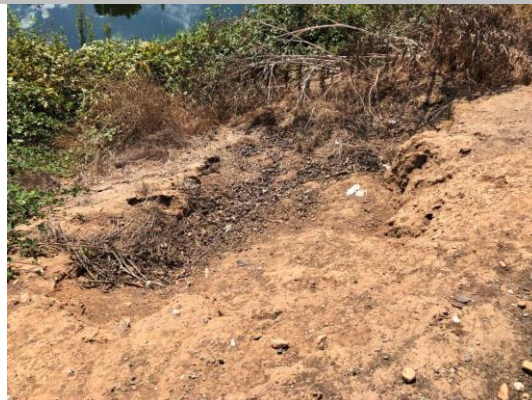
Photo 1 of 2 : SJR2019_DWR_NA0017_15_s _ 2016_202_1.jpg

LM Start	5.52	Rating **	A/W	Issue No.	130
LM End	5.52	Issue Type +	Ma	Location *	
Category	Supplemental			GPS Latitude/Longitude	
				Start	End
Item	DWR Erosion Survey			37.997257°	37.997257°
				-121.078775°	-121.078775°
DWR ID	NA0017U15RM17.67				
Comment Code					
Inspector Comment					
Site ID: NA0017U15RM17.67 08/28/2019: The erosion is located at the upper slope of the channel bank, and was likely caused by rainfall runoff. This area is patrol road only.

Looking down at the erosion from the levee top.

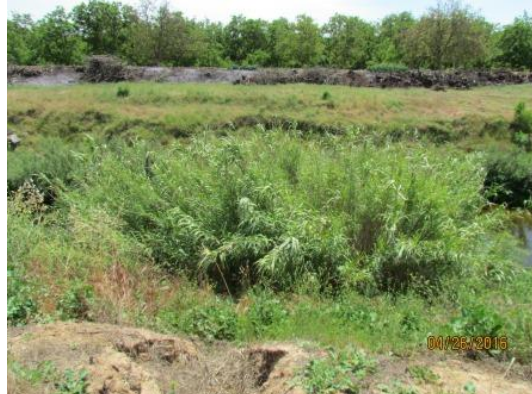
Photo 1 of 1 : FA_2019_NA0017_159_82_20190830_00052.jpg

LM Start	8.39	Rating **	M	Issue No.	82
LM End	8.39	Issue Type +	Ma	Location *	WS
Category	Rivers, Channels & Designated Floodways			GPS Latitude/Longitude	
				Start	End
Item	Vegetation & Obstructions			37.969776 °	37.969776 °
				-121.116070 °	-121.116070 °
DWR ID	DWR_NA0017_15_s_2017_82				
Comment Code					
Inspector Comment					
Clear out vegetation in the channel before it becomes more obstructed

View of arundo on the waterside toe of the levee.

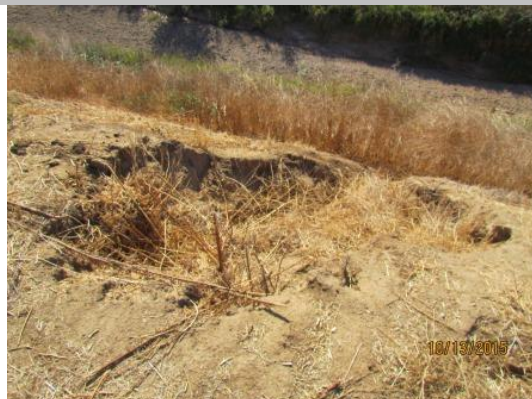
Photo 1 of 2 : FA_2019_NA0017_159_65_20190830_00045.jpg

LM Start	8.43	Rating **	A/W	Issue No.	65
LM End	8.43	Issue Type +	Ma	Location *	WS
Category	Earthen Levee			GPS Latitude/Longitude	
				Start	End
Item	Erosion / Bank Caving			37.969699 °	37.969699 °
				-121.116796 °	-121.116796 °
DWR ID	DWR_NA0017_15_f_2018_65				
Comment Code					
E1 : Note and monitor erosion site.					
Inspector Comment					
Monitor erosion site but should repair before it impacts patrol road.

Picture of the slope instability on the waterside of the levee looking upstream during fall 2015 inspection.

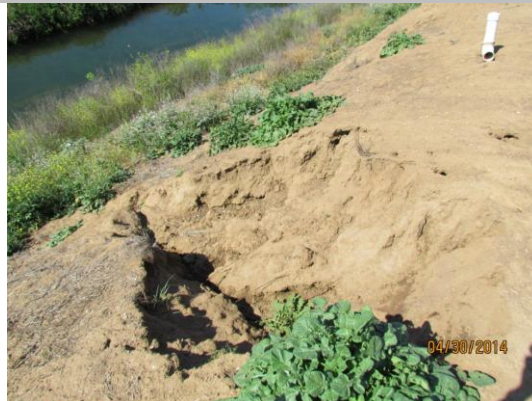
Photo 2 of 2 : FA_2019_NA0017_159_65_20190830_00046.jpg

View of the slope instability on the waterside of the levee looking downstream during spring 2014 inspection.

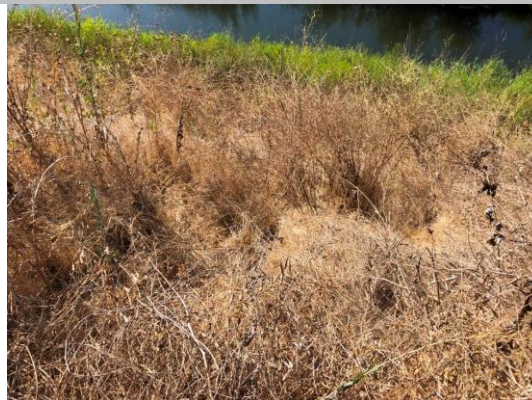
Photo 1 of 3 : SJR2019_NA0017U15RM14.49_1.JPG

LM Start	8.43	Rating **	A/W	Issue No.	84
LM End	8.43	Issue Type +	Ma	Location *	
Category	Supplemental			GPS Latitude/Longitude	
				Start	End
Item	DWR Erosion Survey			37.969711 °	37.969711 °
				-121.116739 °	-121.116739 °
DWR ID	NA0017U15RM14.49				
Comment Code					
Inspector Comment					
Site ID: NA0017U15RM14.49					
08/29/2019: No significant change observed. More vegetation was observed at the site. This area is patrol road only.					
08/30/2017: No significant change observed.					
08/16/2016: The erosion was not visible due to dense vegetation at the site.					
08/12/2015: No significant change observed. More vegetation is observed at the site.					
08/20/2014: No significant change observed.					
09/12/2013: The erosion has been caused by runoff.

Looking down at the erosion site from the levee crest. Erosion was covered by dried vegetation.

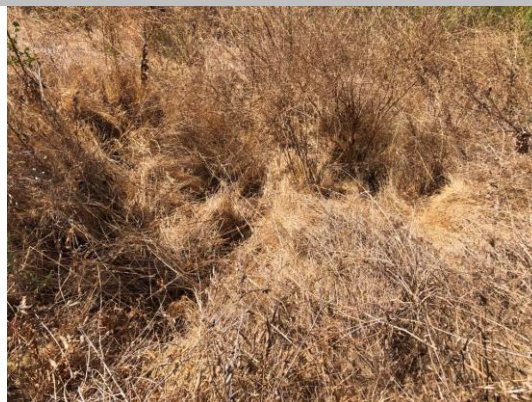
Photo 2 of 3 : SJR2019_NA0017U15RM14.49_2.JPG

Close-up view of the erosion site covered by dense vegetation.

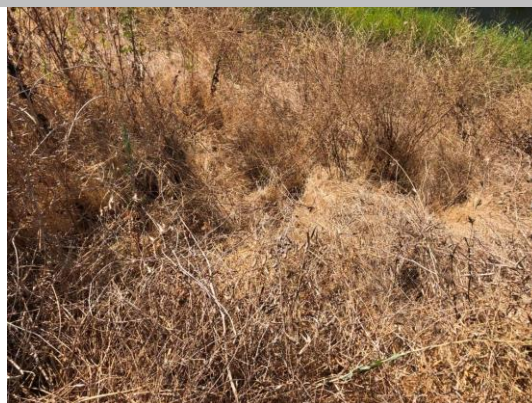
Photo 3 of 3 : SJR2019_NA0017U15RM14.49_3.JPG

LM Start	8.43	Rating **	A/W	Issue No.	84 (cont)	
LM End	8.43	Issue Type +	Ma	Location *		
Category	Supplemental			GPS Latitude/Longitude		
				Start	End	
Item	DWR Erosion Survey			37.969711 °	37.969711 °	
				-121.116739 °	-121.116739 °	
DWR ID	NA0017U15RM14.49					
Comment Code						
Inspector Comment						
Site ID: NA0017U15RM14.49						
08/29/2019: No significant change observed. More vegetation was observed at the site. This area is patrol road only.						
08/30/2017: No significant change observed.						
08/16/2016: The erosion was not visible due to dense vegetation at the site.						
08/12/2015: No significant change observed. More vegetation is observed at the site.						
08/20/2014: No significant change observed.						
09/12/2013: The erosion has been caused by runoff.

Close-up view of the erosion site.

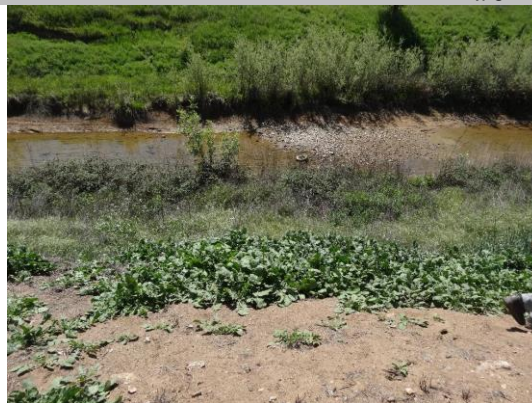
Photo 1 of 3 : UCIP_FA_2019_40386_63765.jpg

LM Start	8.46	Rating **	M	Issue No.	1175	
LM End	8.46	Issue Type +	Ma	Location *		
Category	Supplemental			GPS Latitude/Longitude		
				Start	End	
Item	DRAFT DWR UCIP LMA Responsibility			37.969690 °	37.969690 °	
				-121.117404 °	-121.117404 °	
DWR ID	23227					
Comment Code						
Inspector Comment						
DS_ID:23227						
FS_ID:40386						
EP_NO: N/A						
Repair Type: Non-Urgent						
Crossing Status: Found						
UCIP Comments: Distorted inlet pipe opening on landside. No pipe found on waterside. Dense vegetation and steep slope on waterside.						
FIELD_STRUCT_DESC: 18-inch CM pipe through the levee, 1.0 feet below the crown. O&M Manual SJR Assumed 999.						
FS Date: 4/10/2014

WS view: no pipe or appurtenances found on waterside. Dense vegetation.

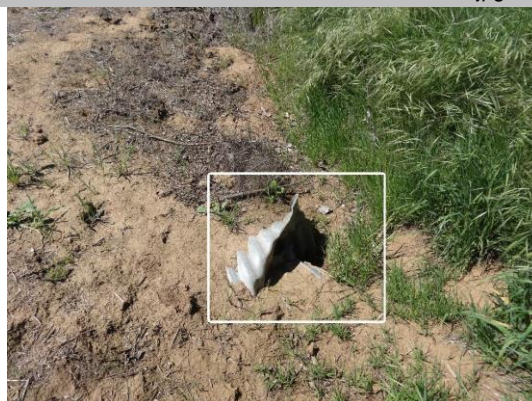
Photo 2 of 3 : UCIP_FA_2019_40386_63764.jpg

LS view: distorted CM outlet pipe on levee slope.

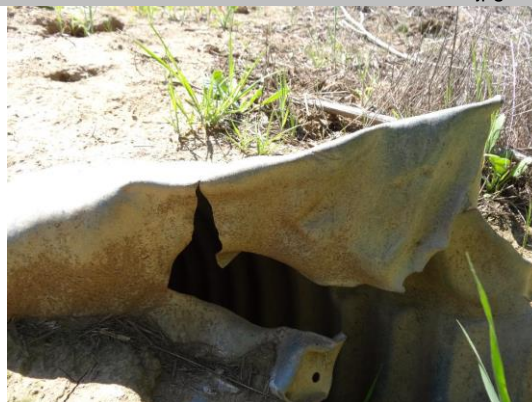
Photo 3 of 3 : UCIP_FA_2019_40386_63763.jpg

LS view: closer view of distorted CM outlet pipe on levee slope.

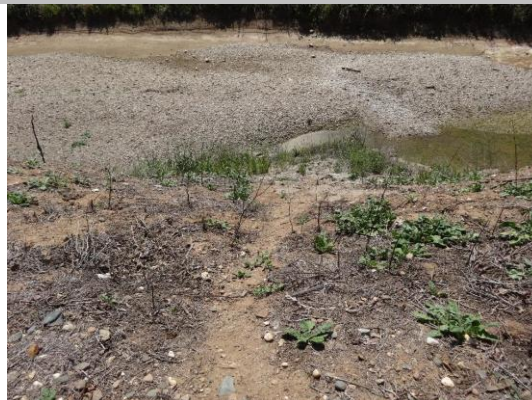
Photo 1 of 2 : UCIP_FA_2019_40387_62949.jpg

LM Start	8.69	Rating **	M	Issue No.	1176	
LM End	8.69	Issue Type +	Ma	Location *		
Category	Supplemental			GPS Latitude/Longitude		
				Start	End	
Item	DRAFT DWR UCIP LMA Responsibility			37.968500 °	37.968500 °	
				-121.121130 °	-121.121130 °	
DWR ID	23229					
Comment Code						
Inspector Comment						
DS_ID:23229 FS_ID:40387 EP_NO: N/A Repair Type: Non-Urgent Crossing Status: Found UCIP Comments: Distorted pipe opening on landside. Inlet pipe needs clearing and cleaning.No pipe visible on waterside. FIELD_STRUCT_DESC: 18-inch corrugated metal drainage pipe and electrical conduit of an unknown material through the levee, 1 foot below the crown. Power pole on the landside (LS). Electrical conduit through the levee. Outlet of pipe rock revetted. [Additional Reference(s): DWR Levee Log, 1992. USACE San Joaquin O&M Manual 611.1, Volume F, (HLM 8.88)]. FS Date: 4/10/2014

WS view: no pipe or appurtenances found. Steep levee slope.

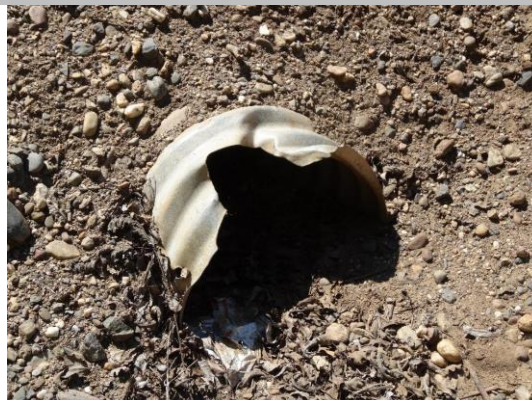
Photo 2 of 2 : UCIP_FA_2019_40387_62948.jpg

LS view: distorted CM inlet pipe. Partially buried.

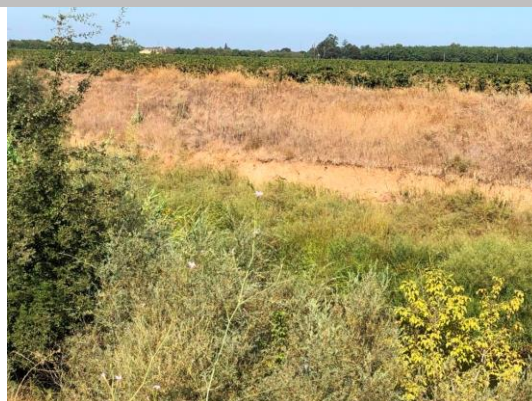
Photo 1 of 3 : SJR2019_NA0017U15RM13.87_1.JPG

LM Start	8.81	Rating **	A/W	Issue No.	7
LM End	8.83	Issue Type +	Ma	Location *	
Category	Supplemental			GPS Latitude/Longitude	
				Start	End
Item	DWR Erosion Survey			37.968060 °	37.968060 °
				-121.123299 °	-121.123299 °
DWR ID	NA0017U15RM13.87				
Comment Code					
Inspector Comment					
Site ID: NA0017U15RM13.87					
08/29/2019: No significant change observed, this area only has patrol road.					
08/30/2017: No significant change observed.					
08/16/2016: No significant change observed.					
08/12/2015: No significant change observed.					
08/20/2014: Both ends of the erosion site are protected by riprap.

View of the site from left river bank.

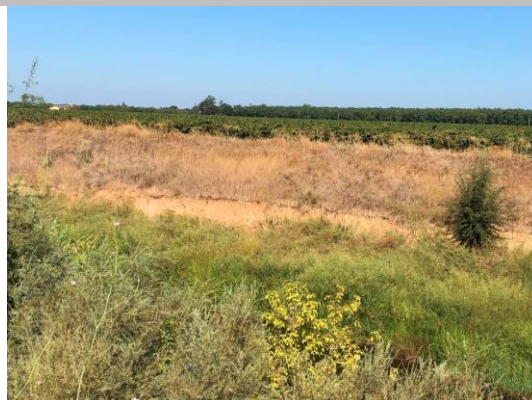
Photo 2 of 3 : SJR2019_NA0017U15RM13.87_3.JPG

Close-up view of the erosion.

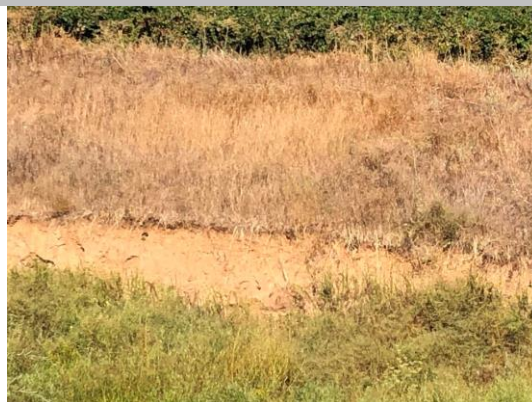
Photo 3 of 3 : SJR2019_NA0017U15RM13.87_4.JPG

Close-up view of the erosion.

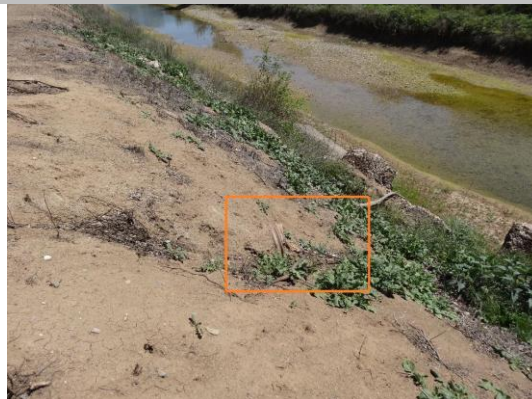
Photo 1 of 3 : UCIP_FA_2019_34983_62966.jpg

LM Start	9.55	Rating **	M	Issue No.	1178	
LM End	9.55	Issue Type +	Ma	Location *		
Category	Supplemental			GPS Latitude/Longitude		
				Start	End	
Item	DRAFT DWR UCIP LMA Responsibility			37.966327°	37.966327°	
				-121.135980°	-121.135980°	
DWR ID	23233					
Comment Code						
Inspector Comment						
DS_ID:23233						
FS_ID:34983						
EP_NO: N/A						
Repair Type: Non-Urgent						
Crossing Status: Found						
UCIP Comments: Needs clearing and cleaning of the pipe.						
FIELD_STRUCT_DESC: 18-inch corrugated metal drainage pipe through the levee, 3.5 feet below the crown. Pipe discharges onto waterside (WS) slope. Slope eroding. [Additional Reference(s): DWR Levee Log, 1992. USACE San Joaquin O&M Manual 611.1, Volume F, (HLM 9.75)].						
FS Date: 4/10/2014

WS view: CM outlet pipe on levee slope.

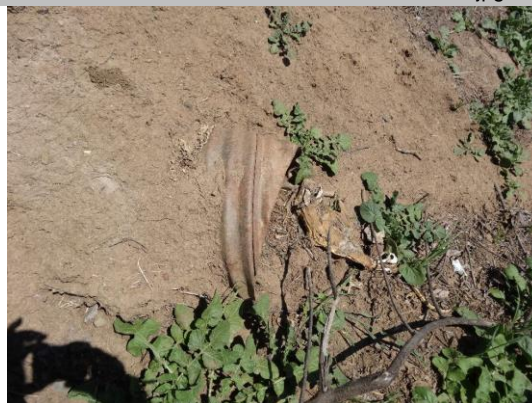
Photo 2 of 3 : UCIP_FA_2019_34983_62965.jpg

WS view: CM outlet pipe on levee slope.

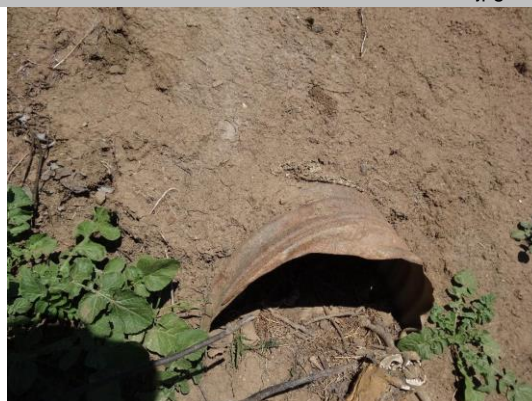
Photo 3 of 3 : UCIP_FA_2019_34983_62964.jpg

WS view: closer view of CM outlet pipe on levee slope.

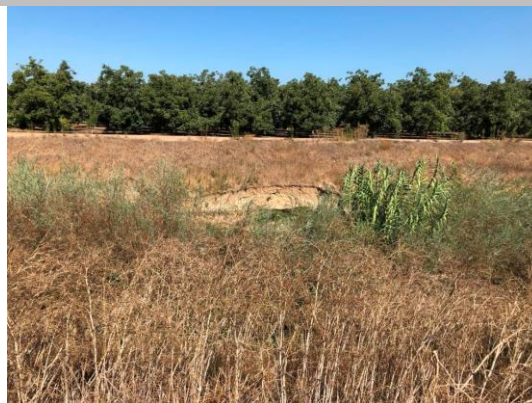
Photo 1 of 3 : SJR2019_DWR_NA0017_15_f_2017_183_1.JPG

LM Start	9.61	Rating **	A/W	Issue No.	6	
LM End	9.63	Issue Type +	Ma	Location *		
Category	Supplemental			GPS Latitude/Longitude		
				Start		End
Item	DWR Erosion Survey			37.965693 °		37.965693 °
				-121.137063 °		-121.137063 °
DWR ID	NA0017U15RM13.25					
Comment Code						
Inspector Comment						
Site ID: NA0017U15RM13.25 08/28/2019: The erosion is located at the lower slope of the channel bank, and is covered by dense vegetation. This area is patrol road only.

Looking at the erosion from other side of the channel.

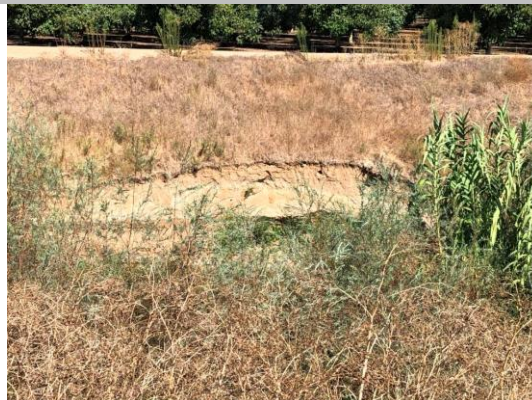
Photo 2 of 3 : SJR2019_DWR_NA0017_15_f_2017_183_2.JPG

Close view of the erosion.

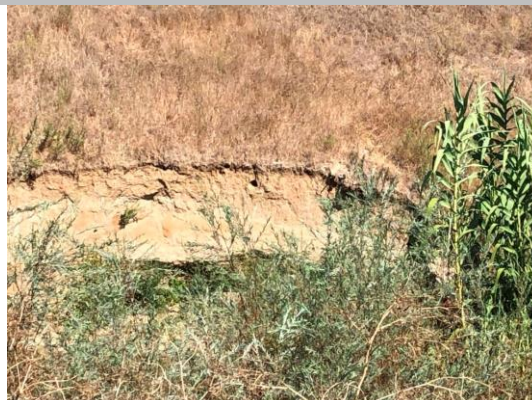
Photo 3 of 3 : SJR2019_DWR_NA0017_15_f_2017_183_3.JPG

Close-up view of the erosion.

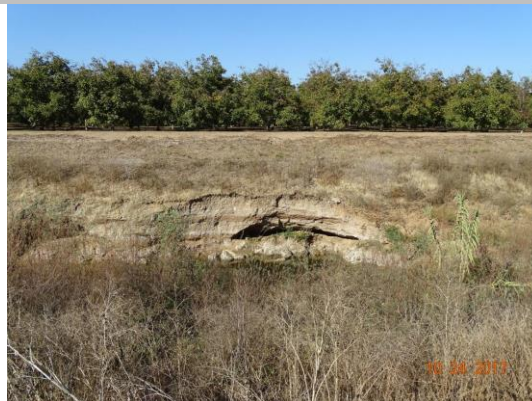
Photo 1 of 1 : FA_2019_NA0017_159_183_20190830_00095.jpg

LM Start	9.62	Rating **	A/W	Issue No.	183
LM End	9.62	Issue Type +	Ma	Location *	WS
Category	Earthen Levee			GPS Latitude/Longitude	
				Start	End
Item	Erosion / Bank Caving			37.965693 °	37.965693 °
				-121.137063 °	-121.137063 °
DWR ID	DWR_NA0017_15_f_2017_183				
Comment Code					
E1 : Note and monitor erosion site.					
Inspector Comment					
Erosion was found on the waterside toe of the levee. It possibly could be a beaver den at this location.

View of an erosion with a possible beaver den on the waterside toe of the levee. The picture was taken from the opposite side of the levee. Fall 2017

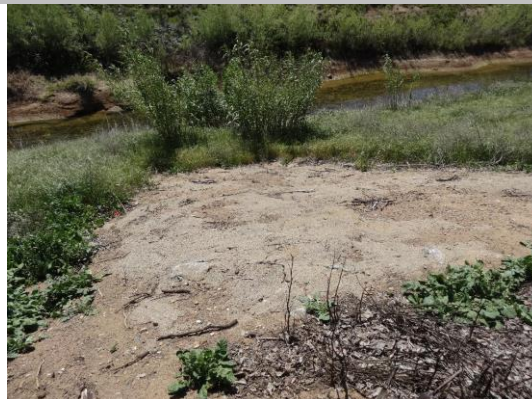
Photo 1 of 3 : UCIP_FA_2019_34986_62986.jpg

LM Start	9.80	Rating **	M	Issue No.	1181	
LM End	9.80	Issue Type +	Ma	Location *		
Category	Supplemental			GPS Latitude/Longitude		
				Start	End	
Item	DRAFT DWR UCIP LMA Responsibility			37.965294 °	37.965294 °	
				-121.140184 °	-121.140184 °	
DWR ID	23235					
Comment Code						
Inspector Comment						
DS_ID:23235 FS_ID:34986 EP_NO: N/A Repair Type: Non-Urgent Crossing Status: Found UCIP Comments: Mud/soil in inlet pipe. Needs cleaning.No pipe or appurtenances visible on waterside. Dense vegetation (may be visible from other channel bank). FIELD_STRUCT_DESC: 18-inch corrugated metal drainage pipe through the levee, 4 feet below the crown. Grouted inlet and outlet. [Additional Reference(s): DWR Levee Log, 1992. USACE San Joaquin O&M Manual 611.1, Volume F, (HLM 10.01)]. FS Date: 4/10/2014

WS view: no pipe or appurtenances found.

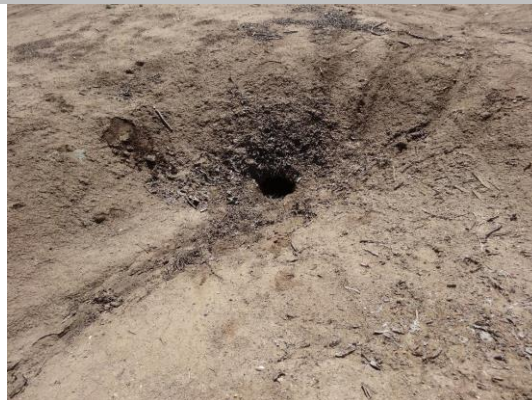
Photo 2 of 3 : UCIP_FA_2019_34986_62985.jpg

LS view: partially buried inlet pipe.

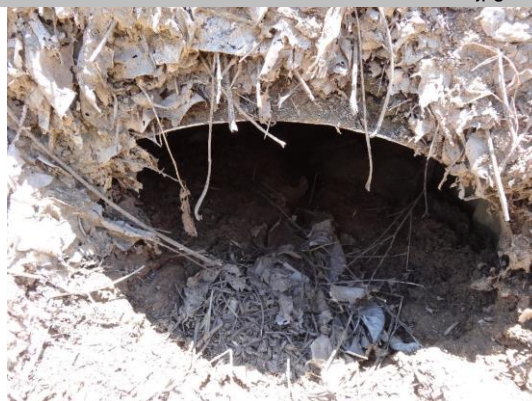
Photo 3 of 3 : UCIP_FA_2019_34986_62984.jpg

LS view: closer view of partially buried inlet pipe. Needs cleaning and clearing.

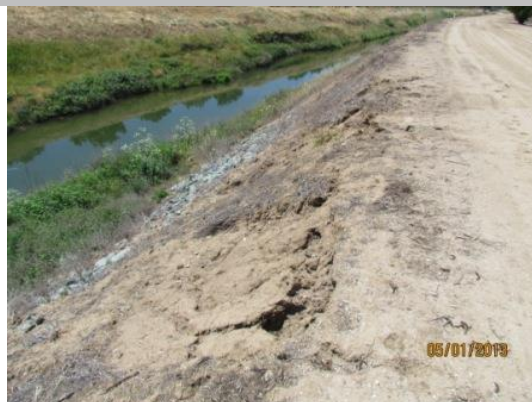
Photo 1 of 1 : FA_2019_NA0017_159_68_20190830_00049.jpg

LM Start	9.90	Rating **	A/W	Issue No.	68
LM End	9.90	Issue Type +	Ma	Location *	WS
Category	Earthen Levee			GPS Latitude/Longitude	
				Start	End
Item	Erosion / Bank Caving			37.965165 °	37.965165 °
				-121.141928 °	-121.141928 °
DWR ID	DWR_NA0017_15_s_2013_68				
Comment Code					
E1 : Note and monitor erosion site.					
Inspector Comment					
This portion of the levee is non-project. Therefore, the rating was given as A/W.

Slope instability was found on the waterside slope of the levee looking downstream.

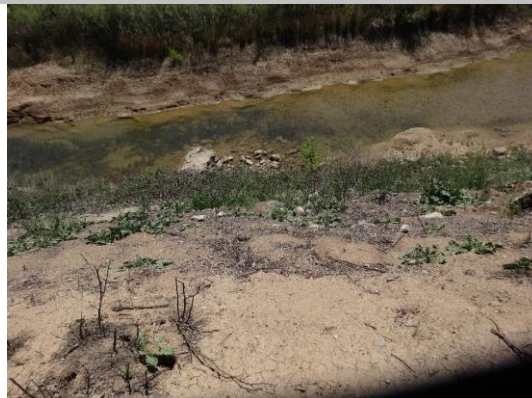
Photo 1 of 3 : UCIP_FA_2019_34987_62992.jpg

LM Start	10.01	Rating **	M	Issue No.	1182	
LM End	10.01	Issue Type +	Ma	Location *		
Category	Supplemental			GPS Latitude/Longitude		
				Start	End	
Item	DRAFT DWR UCIP LMA Responsibility			37.965085 °	37.965085 °	
				-121.143999 °	-121.143999 °	
DWR ID	23236					
Comment Code						
Inspector Comment						
DS_ID:23236						
FS_ID:34987						
EP_NO: N/A						
Repair Type: Non-Urgent						
Crossing Status: Found						
UCIP Comments: May need cleaning of the pipe.Pipe not visible on waterside.						
FIELD_STRUCT_DESC: 18-inch corrugated metal drainage pipe through the levee, 4.5 feet below the crown. Grouted inlet and outlet.						
[Additional Reference(s): DWR Levee Log, 1992. USACE San Joaquin O&M Manual 611.1, Volume F, (HLM 10.22)].						
FS Date: 4/10/2014

WS view: no pipe or appurtenances found.

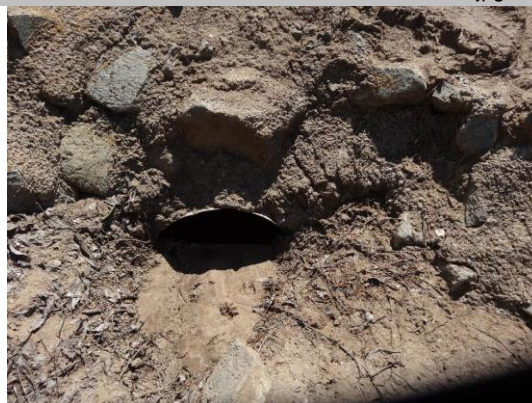
Photo 2 of 3 : UCIP_FA_2019_34987_62990.jpg

LS view: partially buried inlet pipe on levee toe.

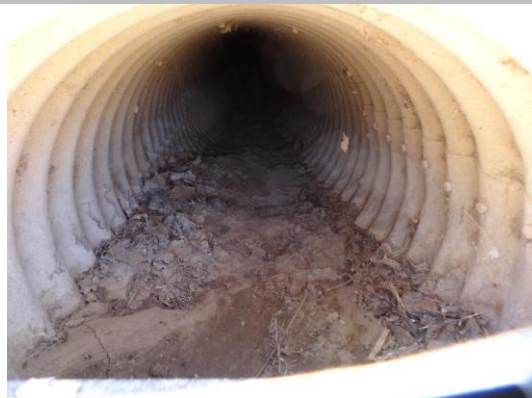
Photo 3 of 3 : UCIP_FA_2019_34987_62991.jpg

LS view: inside view of partially buried inlet pipe. Needs cleaning.

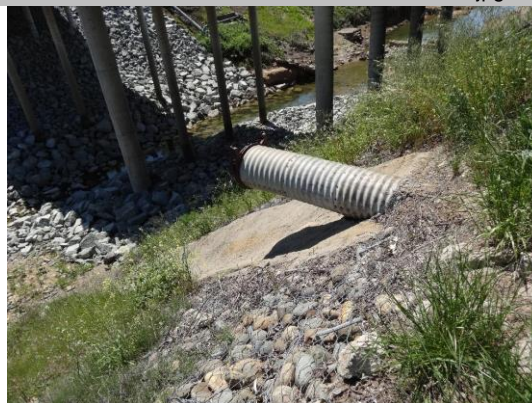
Photo 1 of 2 : UCIP_FA_2019_35003_63003.jpg

LM Start	10.26	Rating **	A/W	Issue No.	1183	
LM End	10.26	Issue Type +	Ma	Location *		
Category	Supplemental			GPS Latitude/Longitude		
				Start	End	
Item	DRAFT DWR UCIP LMA Responsibility			37.965104 °	37.965104 °	
				-121.148460 °	-121.148460 °	
DWR ID	23237					
Comment Code						
Inspector Comment						
DS_ID:23237						
FS_ID:35003						
EP_NO: N/A						
Repair Type: No Action Needed						
Crossing Status: Found						
UCIP Comments: May need cleaning of the inlet pipe. Vegetation debris on inlet box.						
FIELD_STRUCT_DESC: 18-inch corrugated metal drainage pipe through the levee, 7.5 feet below the crown. Concrete U-shaped headwall on the landside (LS). Flap gate on the waterside (WS).						
[Additional Reference(s): DWR Levee Log, 1992. USACE San Joaquin O&M Manual 611.1, Volume F, (HLM 10.47)].						
FS Date: 4/10/2014

WS view: CM outfall pipe with flapgate on levee slope.

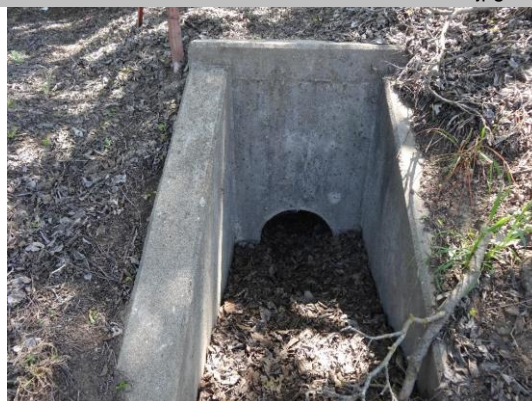
Photo 2 of 2 : UCIP_FA_2019_35003_63002.jpg

LS view: concrete headwall and inlet pipe. Needs cleaning of debris.

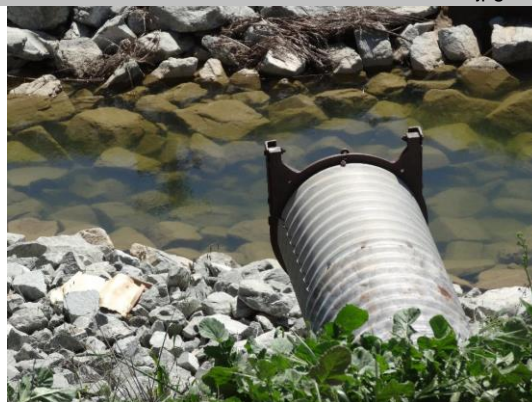
Photo 1 of 2 : UCIP_FA_2019_35005_63011.jpg

LM Start	10.27	Rating **	M	Issue No.	1185	
LM End	10.27	Issue Type +	Ma	Location *		
Category	Supplemental			GPS Latitude/Longitude		
				Start	End	
Item	DRAFT DWR UCIP LMA Responsibility			37.965097 °	37.965097 °	
				-121.148671 °	-121.148671 °	
DWR ID	23238					
Comment Code						
Inspector Comment						
DS_ID:23238						
FS_ID:35005						
EP_NO: N/A						
Repair Type: Non-Urgent						
Crossing Status: Found						
UCIP Comments: Pipe buried on landside. May need cleaning of vegetation debris in inlet opening.						
FIELD_STRUCT_DESC: 18-inch corrugated metal drainage pipe through the levee, 7.5 feet below the crown. Flap gate on the waterside (WS). [Additional Reference(s): DWR Levee Log, 1992. USACE San Joaquin O&M Manual 611.1, Volume F, (HLM 10.49)].						
FS Date: 4/10/2014

WS view: CM outfall pipe with flapgate on levee slope.

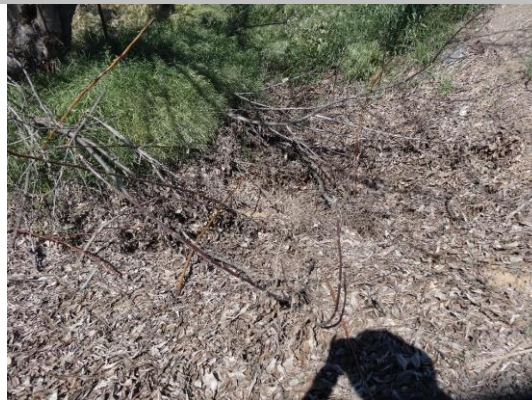
Photo 2 of 2 : UCIP_FA_2019_35005_63010.jpg

LS view: vegetation debris in inlet area. Needs cleaning and clearing.

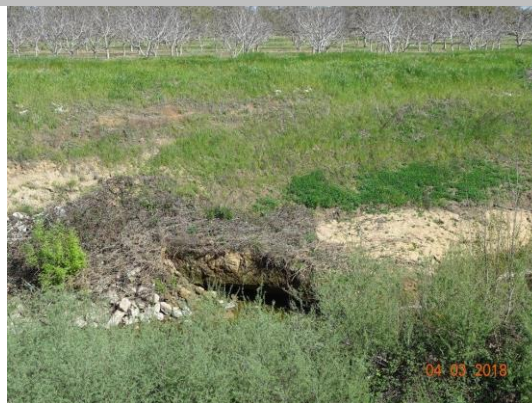
Photo 1 of 1 : FA_2019_NA0017_159_143_20190830_00069.jpg

LM Start	10.75	Rating **	U	Issue No.	143
LM End	10.75	Issue Type +	Ma	Location *	WS
Category	Earthen Levee			GPS Latitude/Longitude	
				Start	End
Item	Erosion / Bank Caving			37.963449 °	37.963449 °
				-121.157018 °	-121.157018 °
DWR ID	DWR_NA0017_15_s_2018_143				
Comment Code					
E2 : Schedule repair of erosion site prior to the next inspection.					
Inspector Comment					
This is non-project levee patrol road. Erosion could potentially impact patrol road.

Erosion bank caving waterside taken from opposite bank looking north.

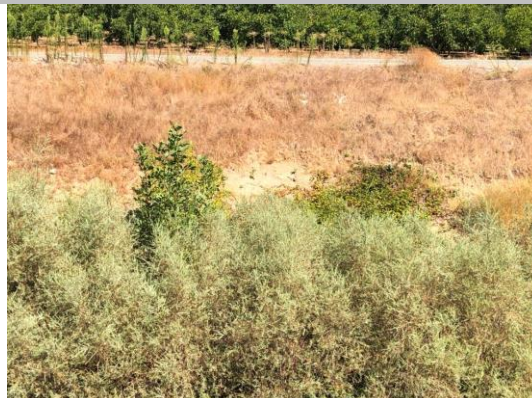
Photo 1 of 2 : SJR2019_DWR_NA0017_15_s_2018_143_1.JPG

LM Start	10.75	Rating **	A/W	Issue No.	5	
LM End	10.75	Issue Type +	Ma	Location *		
Category	Supplemental			GPS Latitude/Longitude		
				Start		End
Item	DWR Erosion Survey			37.963449 °	37.963449 °	
				-121.157018 °	-121.157018 °	
DWR ID	NA0017U15RM12.12					
Comment Code						
Inspector Comment						
Site ID: NA0017U15RM12.12						
08/28/2019: The erosion is located at the lower slope of the channel bank, and is covered by dense vegetation. This area is patrol road only.

Looking at the erosion from the other side of the channel.

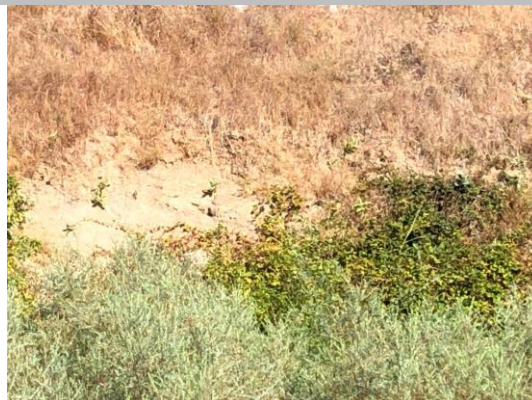
Photo 2 of 2 : SJR2019_DWR_NA0017_15_s_2018_143_3.JPG

Close-up view of the erosion.

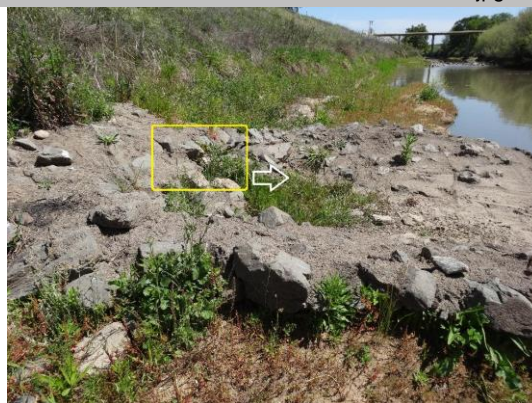
Photo 1 of 2 : UCIP_FA_2019_35010_63035.jpg

WS view: outlet pipe on grouted riprap on levee slope.

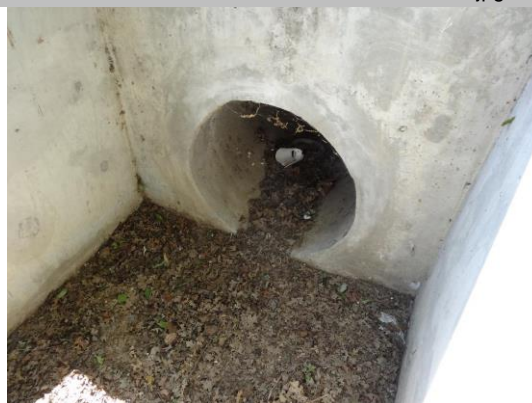
Photo 2 of 2 : UCIP_FA_2019_48304_63038.jpg

LS view: inlet pipe and headwall on levee toe. May need cleaning of inlet opening.

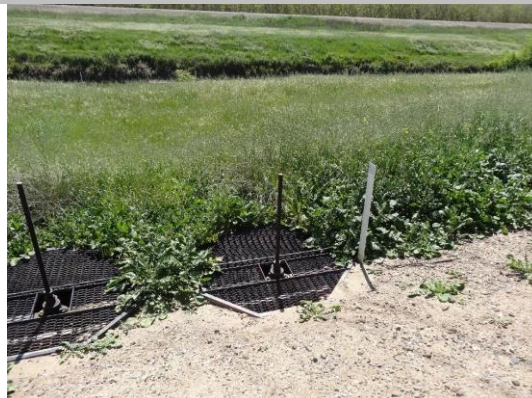
Photo 1 of 3 : UCIP_FA_2019_35014_63053.jpg

Comment Code						
Inspector Comment						
DS_ID:23247						
FS_ID:35014						
EP_NO: N/A						
Repair Type: No Action Needed						
Crossing Status: Found						
UCIP Comments: May need mud and debris cleaning.						
FIELD_STRUCT_DESC: 1 of 2: 48-inch drainage pipe of an unknown material through the levee, 11.5 feet below the crown. Slide gate in corrugated metal riser unit on the waterside (WS) slope. Concrete U-shaped headwall on both ends. Flap gates. Grouted rock spillway. [Additional Reference(s): DWR Levee Log, 1992. USACE San Joaquin O&M Manual 611.1, Volume F, (HLM 12.65) corrugated metal pipe listed].						
FS Date: 4/14/2014

WS view: slide gates in CMP risers on levee slope.

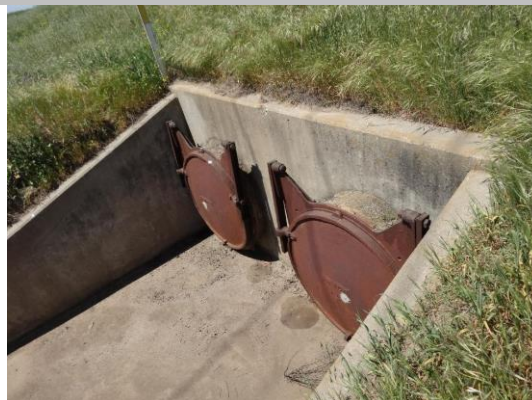
Photo 2 of 3 : UCIP_FA_2019_35014_63052.jpg

WS view: flap gates and headwall on levee slope.

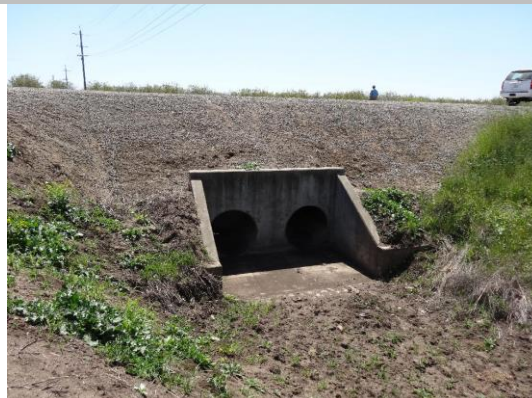
Photo 3 of 3 : UCIP_FA_2019_35014_63051.jpg

LS view: headwall and inlet pipes on levee slopes.

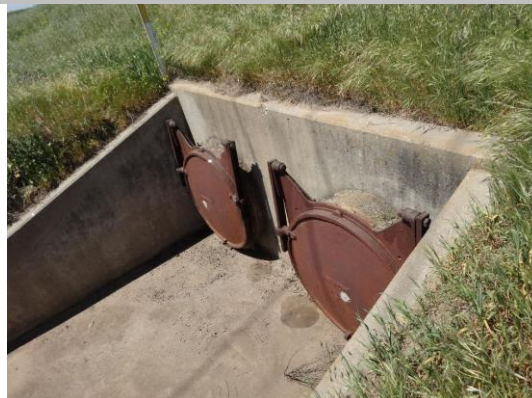
Photo 2 of 3 : UCIP_FA_2019_35015_63058.jpg

WS view: headwall and flap gates on CMP ends on levee slope.

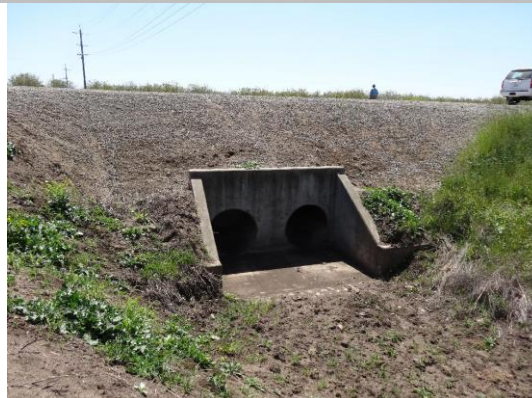
Photo 3 of 3 : UCIP_FA_2019_35015_63057.jpg

LS view: headwall and inlet pipes on levee slope.

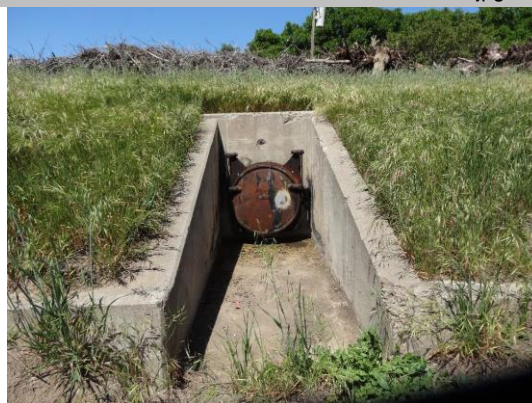
Photo 1 of 3 : UCIP_FA_2019_35043_63085.jpg

WS view: U type concrete headwall, CM pipe with flapgate, and concrete spillway on levee slope.

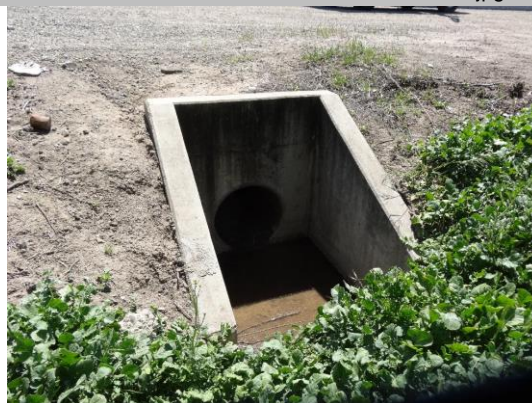
Photo 2 of 3 : UCIP_FA_2019_35043_63084.jpg

LS view: U type concrete headwall and CM inlet Pipe on levee slope.
Soil/mud on inlet box.

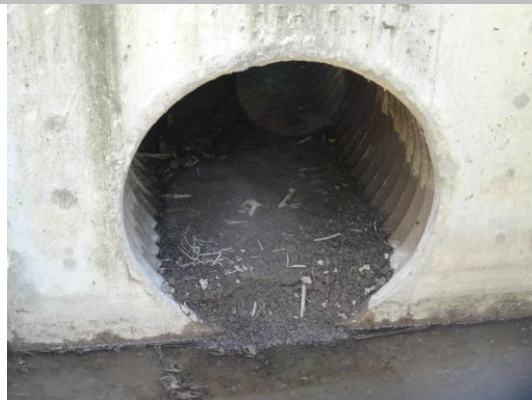
Photo 3 of 3 : UCIP_FA_2019_35043_63083.jpg

LS view: inside view of the CM pipe. Needs cleaning and clearing the pipe.

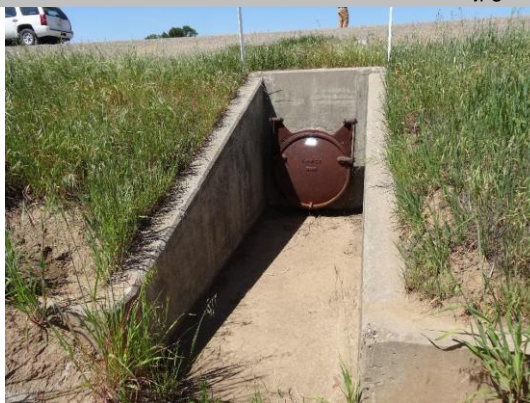
Photo 1 of 3 : UCIP_FA_2019_35047_63100.jpg

WS view: U type concrete headwall, CM pipe with flapgate, and concrete spillway on levee slope.

DS_ID:23252
FS_ID:35047
EP_NO: N/A
Repair Type: Non-Urgent
Crossing Status: Found
UCIP Comments: Needs pipe cleaning.
FIELD_STRUCT_DESC: 30-inch corrugated metal drainage pipe through the levee, 8.5 feet below the crown. Concrete U-shaped headwalls on both ends. Grouted spillway on the waterside (WS). Flap gate on the WS end. [Additional Reference(s): DWR Levee Log, 1992. USACE San Joaquin O&M Manual 611.1, Volume F, (HLM 13.43)].
FS Date: 4/14/2014

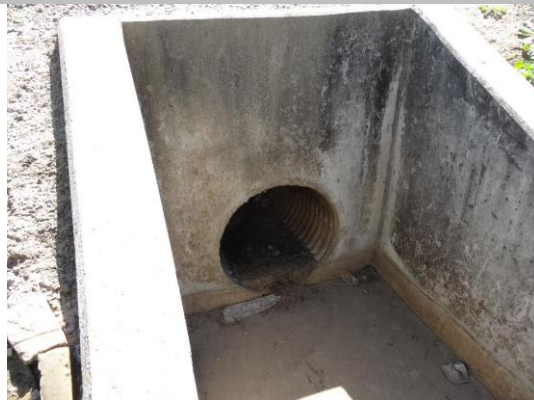
Photo 2 of 3 : UCIP_FA_2019_35047_63099.jpg

LS view: U type concrete headwall and CM inlet Pipe on levee slope.
Soil/mud on inlet box.

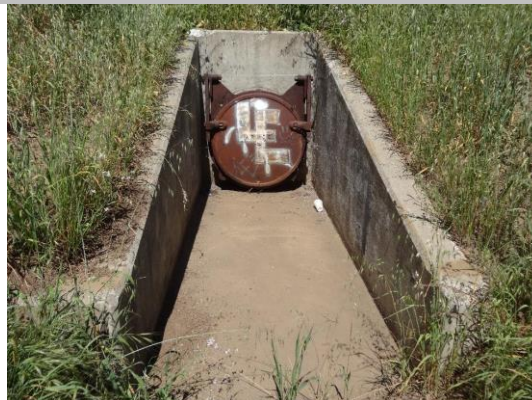
Photo 1 of 3 : UCIP_FA_2019_35049_63113.jpg

WS view: U type concrete headwall, CM pipe with flapgate, and concrete spillway on levee slope.

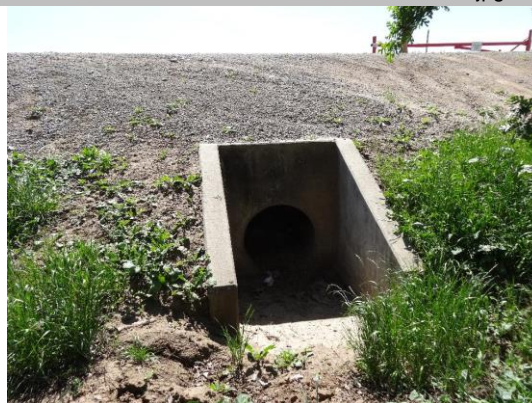
Photo 2 of 3 : UCIP_FA_2019_35049_63112.jpg

LS view: U type concrete headwall and CM inlet Pipe on levee slope.
Soil/mud on inlet box.

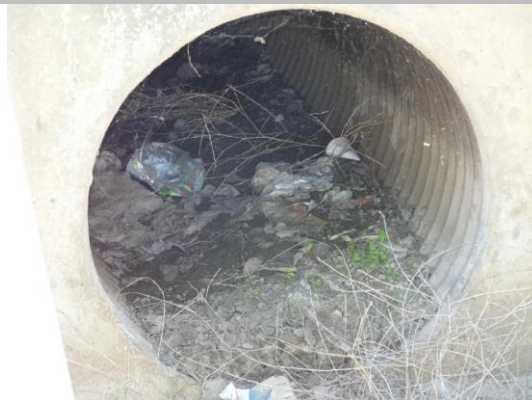
Photo 3 of 3 : UCIP_FA_2019_35049_63111.jpg

LS view: inside view of the CM pipe. Needs cleaning and clearing the pipe.

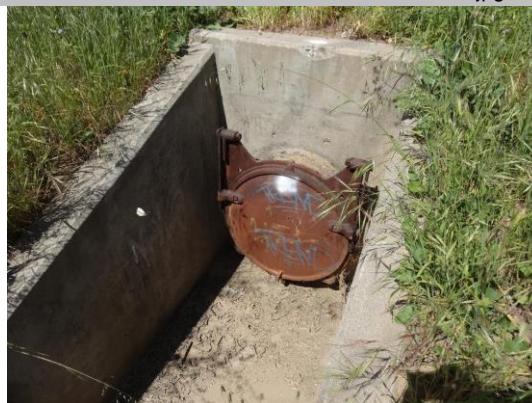
Photo 1 of 3 : UCIP_FA_2019_35064_63131.jpg

WS view: U type concrete headwall, CM pipe with flapgate, and concrete spillway on levee slope.

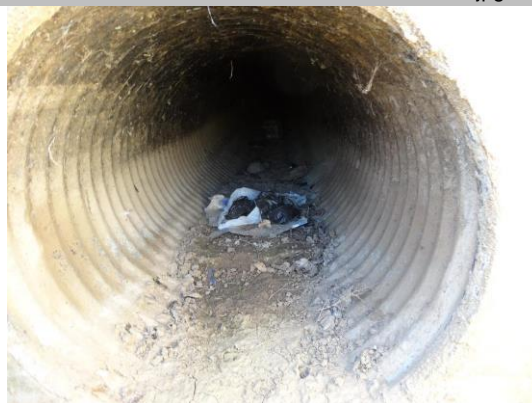
Photo 3 of 3 : UCIP_FA_2019_35104_63193.jpg

LS view: inside view of CM inlet pipe on levee slope. Debris on inlet pipe. Needs cleaning.

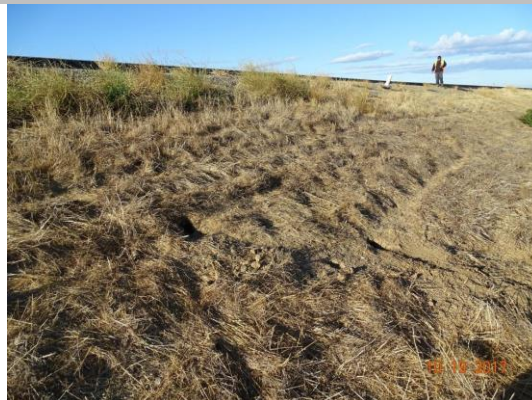
Photo 1 of 1 : FA_2019_NA0017_159_154_20190830_00075.jpg

LM Start	15.37	Rating **	M	Issue No.	154
LM End	15.37	Issue Type +	Ma	Location *	LS
Category	Earthen Levee			GPS Latitude/Longitude	
				Start	End
Item	Animal Control			37.975671 °	37.975671 °
				-121.234277 °	-121.234277 °
DWR ID	DWR_NA0017_15_f_2015_154				
Comment Code					
A3 : No rodents visible, but rodent burrows visible; need to backfill and compact or grout burrows.					
Inspector Comment

View of rodent holes on the landside of the levee. Fall 2017

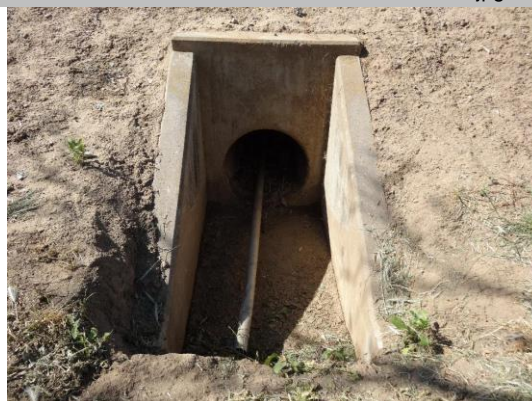
Photo 2 of 2 : UCIP_FA_2019_35105_63196.jpg

LS view: U type concrete headwall and CM pipe on levee slope. Debris in inlet pipe.

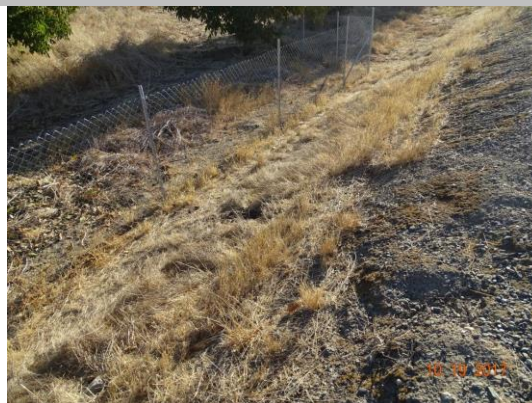
Photo 1 of 2 : FA_2019_NA0017_159_194_20190830_00101.jpg

LM Start	15.40	Rating **	A/W	Issue No.	194
LM End	15.41	Issue Type +	Ma	Location *	LS
Category	Earthen Levee			GPS Latitude/Longitude	
				Start	End
Item	Animal Control			37.975839 °	37.975893 °
				-121.234763 °	-121.234858 °
DWR ID	DWR_NA0017_15_s_2015_194				
Comment Code					
A3 : No rodents visible, but rodent burrows visible; need to backfill and compact or grout burrows.					
Inspector Comment

Picture of the rodent holes on the landside shoulder of the levee. Fall 2017

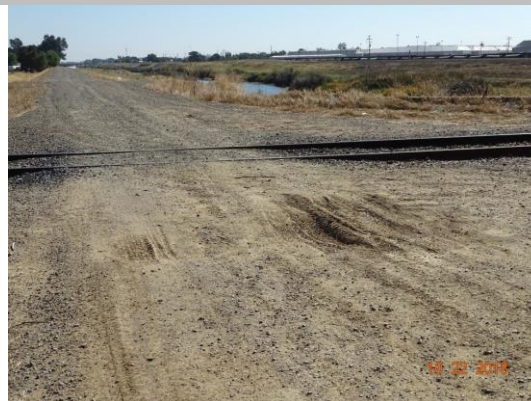
Photo 1 of 1 : FA_2019_NA0017_159_197_20190830_00103.jpg

LM Start	16.00	Rating **	M	Issue No.	197
LM End	16.00	Issue Type +	Ma	Location *	CR
Category	Earthen Levee			GPS Latitude/Longitude	
				Start	End
Item	Crown Surface / Depressions / Rutting			37.980052 °	37.980052 °
				-121.244213 °	-121.244213 °
DWR ID	DWR_NA0017_15_f_2018_197				
Comment Code					
C2 : Repair depressions or ruts in the crown or slope.					
Inspector Comment

View of rut on the access road (October 2018).

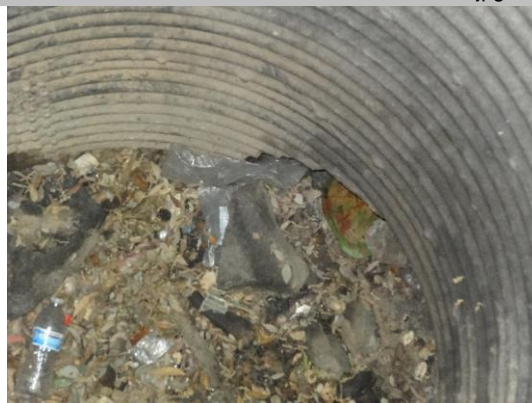
Photo 3 of 3 : UCIP_FA_2019_35183_63323.jpg

DS_ID:23267
FS_ID:35183
EP_NO: N/A
Repair Type: Non-Urgent
Crossing Status: Found
UCIP Comments: CMP riser needs cleaning.
FIELD_STRUCT_DESC: 30-inch corrugated metal drainage pipe through the levee, 13 feet below the crown. Concrete U-shaped headwall on the waterside (WS). Corrugated metal riser unit at the landside (LS) toe. [Additional Reference(s): DWR Levee Log, 1992. USACE San Joaquin O&M Manual 611.1, Volume F, (HLM 18.01)].
FS Date: 4/15/2014

LS view: inside view of CMP riser on levee shoulder. It needs cleaning and clearing.

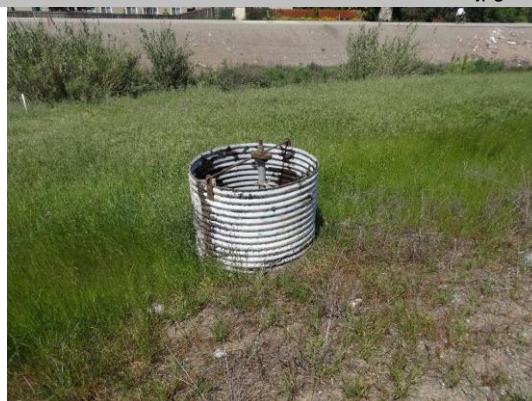
Photo 2 of 3 : UCIP_FA_2019_35203_63344.jpg

WS view: slide gate in CMP riser on levee slope. Slide gate handle missing.

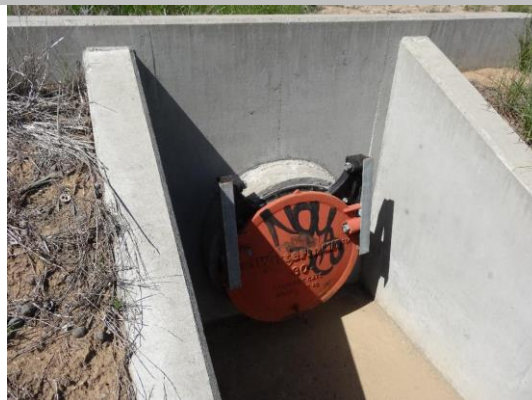
Photo 2 of 3 : UCIP_FA_2019_35206_63360.jpg

WS view: U type concrete headwall, CM pipe with flapgate, and concrete spillway on levee slope.

LM Start	18.88	Rating **	A/W	Issue No.	1218 (cont)	
LM End	18.88	Issue Type +	Ma	Location *		
Category	Supplemental			GPS Latitude/Longitude		
				Start	End	
Item	DRAFT DWR UCIP LMA Responsibility			38.000116°	38.000116°	
				-121.269301°	-121.269301°	
DWR ID	23464					
Comment Code						
Inspector Comment						
DS_ID:23464 FS_ID:35206 EP_NO: N/A Repair Type: No Action Needed Crossing Status: Found UCIP Comments: Slide gate in a concrete box on waterside shoulder. FIELD_STRUCT_DESC: 30-inch reinforced concrete storm drainage pipe through the levee, 6 feet below the crown. Slide gate in a concrete box on the waterside (WS) shoulder. [Additional Reference(s): USACE San Joaquin O&M Manual 611.1, Volume F, (Station 345+65)]. FS Date: 4/15/2014

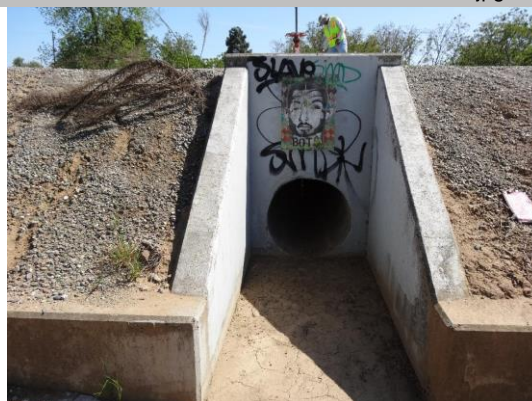
Photo 3 of 3 : UCIP_FA_2019_35206_63359.jpg

LS view: U type concrete headwall and CM pipe on levee slope.

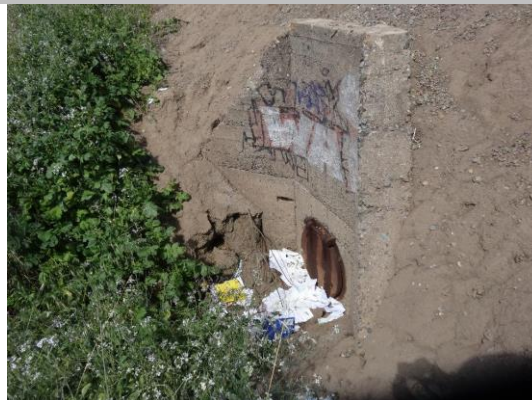
Photo 1 of 3 : UCIP_FA_2019_53535_63421.jpg

DS_ID:23274
FS_ID:53535
EP_NO: N/A
Repair Type: Non-Urgent
Crossing Status: Found
UCIP Comments: 11/16/2018 Internal video inspection revealed a concrete plug in the pipe, 49.2 feet from the outlet on the WS. Pipe improperly abandoned. Abandon properly or remove from levee. Crossing escalated to "Non-Urgent" due to the improper abandonment. Material type changed from steel to reinforced concrete. (A. McDonald - DWR UCIP) Concrete headwall not found on the LS. Manhole found on the LS.
FIELD_STRUCT_DESC: *ABANDONED* 24-inch reinforced concrete gravity drainage pipe through the levee, 12 feet below the crown. Flap gate and concrete headwall on the waterside (WS). Manhole on the landside (LS). Pipe partially plugged with concrete on the LS.
[Additional Reference(s): DWR Levee Log, 1992. USACE San Joaquin O&M Manual 611.1, Volume F, (HLM 20.14)].
FS Date: 11/16/2018

WS view: concrete headwall and steel pipe with flapgate on levee slope.
Vegetation and debris on spillway.

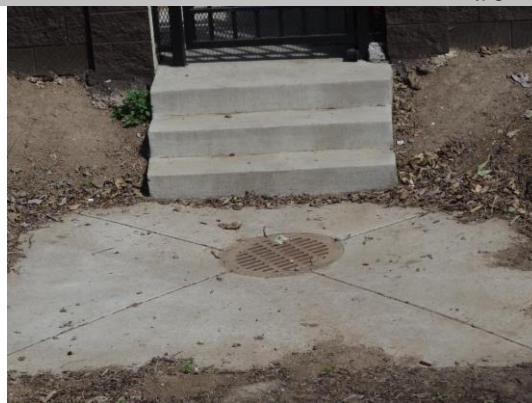
Photo 2 of 3 : UCIP_FA_2019_53535_63420.jpg

LS view: a manhole on levee toe.

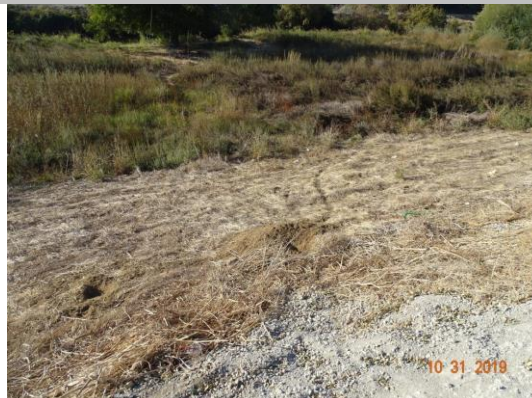
Photo 1 of 2 : FA_2019_NA0017_159_195_20191118_00307.jpg

LM Start	22.51	Rating **	M	Issue No.	195
LM End	22.51	Issue Type +	Ma	Location *	WS
Category	Earthen Levee			GPS Latitude/Longitude	
				Start	End
Item	Animal Control			37.981732°	37.981732°
				-121.324087°	-121.324087°
DWR ID	DWR_NA0017_15_f_2019_195				
Comment Code					
A3 : No rodents visible, but rodent burrows visible; need to backfill and compact or grout burrows.					
Inspector Comment

View of rodent holes on waterside slope. Fall 2019

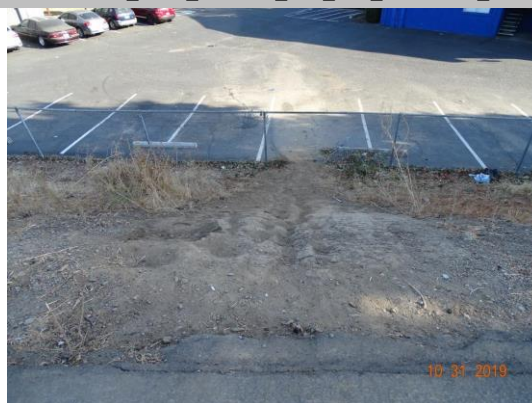
Photo 2 of 2 : FA_2019_NA0017_159_195_20191118_00308.jpg

View of rodent holes on waterside slope. Fall 2019

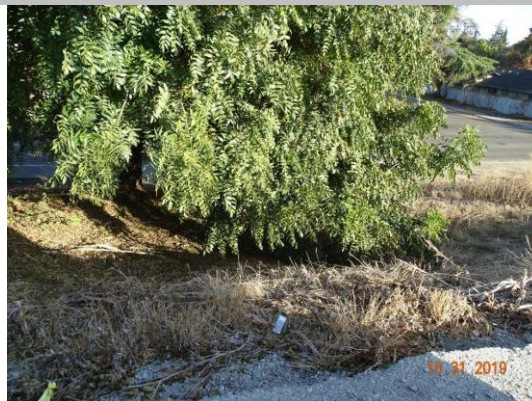
Photo 1 of 1 : FA_2019_NA0017_159_169_20191118_00302.jpg

LM Start	23.38	Rating **	M	Issue No.	169
LM End	23.38	Issue Type +	Ma	Location *	LS
Category	Earthen Levee			GPS Latitude/Longitude	
				Start	End
Item	Trim / Thin Trees			37.980038 °	37.980038 °
				-121.339443 °	-121.339443 °
DWR ID	DWR_NA0017_15_f_2019_169				
Comment Code					
T1 : Trim trees to at least five feet above ground level.					
Inspector Comment

View of tree that needs to be trimmed at least 5 feet above ground on roadside slope. Fall 2019

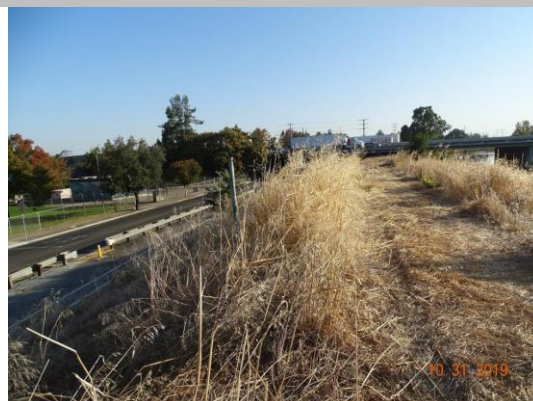
Photo 1 of 1 : FA_2019_NA0017_159_148_20191118_00301.jpg

LM Start	23.58	Rating **	M	Issue No.	148
LM End	23.77	Issue Type +	Ma	Location *	LS
Category	Earthen Levee			GPS Latitude/Longitude	
				Start	End
Item	Vegetation			37.979019°	37.977205°
				-121.342322°	-121.344854°
DWR ID	DWR_NA0017_15_f_2019_148				
Comment Code					
V2 : Remove the wild growth other than native grasses from the levee slopes.					
Inspector Comment

View of vegetation on landside slope. Fall 2019

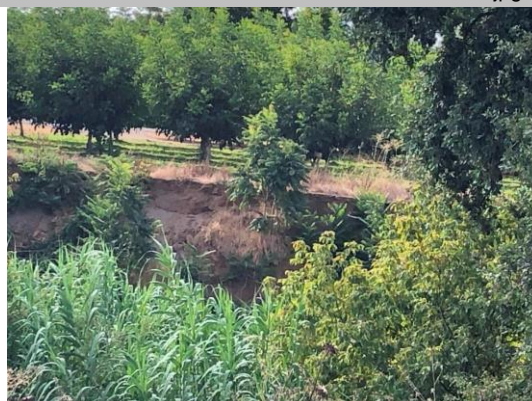
Photo 3 of 3 : SJR2019_NA0017U16RM23.35_7.jpg

Item	DWR Erosion Survey			38.048159 °	38.048159 °	
				-121.016427 °	-121.016427 °	
DWR ID	NA0017U16RM23.35					
Comment Code						
Inspector Comment						
Site ID: NA0017U16RM23.35						
08/28/2019: No significant change observed.						
08/30/2017: The erosion has cut further into the river bank. Newly collapsed material is observed at the bottom of the erosion site.						
08/16/2016: The erosion site was found progressed with signs of bank slipping.						
08/12/2015: The erosion progressed at the site. Newly collapsed material is observed at the bottom of the erosion.						
08/20/2014: The erosion at the site has worsened. The erosion increased in both length and in height.						
09/12/2013: Site has been visited and signs of new erosion are visible.						
08/22/2012: The erosion was surveyed and documented for monitoring purpose. There is no levee structure on the site, only high ground protecting the land behind. The levee crest width and levee height were not measured or estimated in the field.

Close-up view of the erosion.

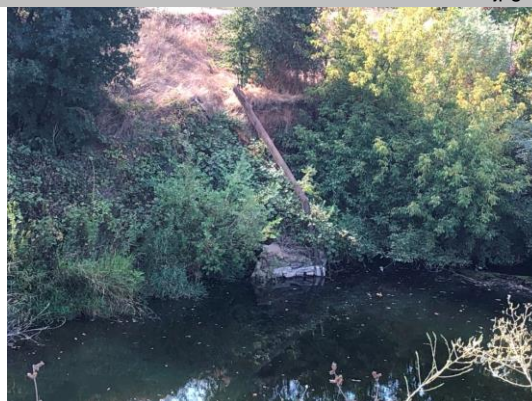
Photo 1 of 3 : SJR2019_NA0017U16RM22.74_1.jpg

Comment Code						
Inspector Comment						
Site ID: NA0017U16RM22.74 08/28/2019: No significant change observed. 08/30/2017: No significant change observed. 08/16/2016: No significant change observed. 08/12/2015: No significant change observed. 08/20/2014: No significant change observed. 09/12/2013: No significant change observed. 08/22/2012: The erosion was surveyed and documented for monitoring purpose. There is no levee structure on the site, only high ground protecting the land behind. The levee crest width and levee height were not measured or estimated in the field. There is a drainage pipe at the site, which might have caused the problem at one pocket erosion.

View of the site from right river bank.

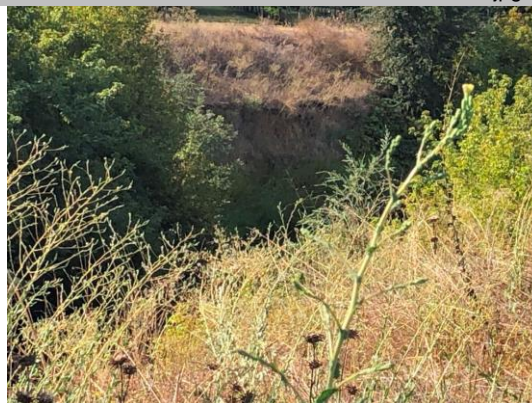
Photo 2 of 3 : SJR2019_NA0017U16RM22.74_3.jpg

Close-up view of the erosion.
