**Flood Control Project Maintenance
Levee Inspections**

Maintenance Issue Types Only, Levee Inspection Report By Mile - Fall 2019

San Joaquin County Flood Control and Water Conservation District

Waterway	Bank	Unit Miles	Inspection Start/End	Inspector
Unit No. 01 Littlejohn Creek	Left	2.59	11/14/2019 11/14/2019	Alberto De Leon

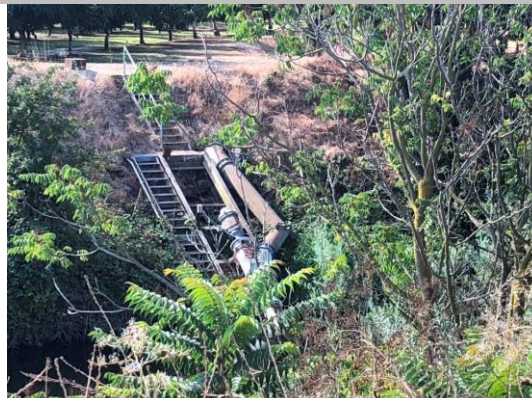
Photo 2 of 3 : SJR2019_NA0017U16RM22.58_2.jpg

Site ID: NA0017U16RM22.58
 08/28/2019: No significant change observed.
 08/30/2017: No significant change observed.
 08/16/2016: No significant change observed.
 08/12/2015: No significant change observed.
 08/20/2014: No significant change observed.
 09/12/2013: No significant change observed.
 08/22/2012: The erosion is at the outside corner of a river bend, and next to a tree at the levee toe. Irrigation structure presents at the site. There is no levee structure on site. The levee crest width and levee height were not measured or estimated in the field.

Close-up view of the erosion.

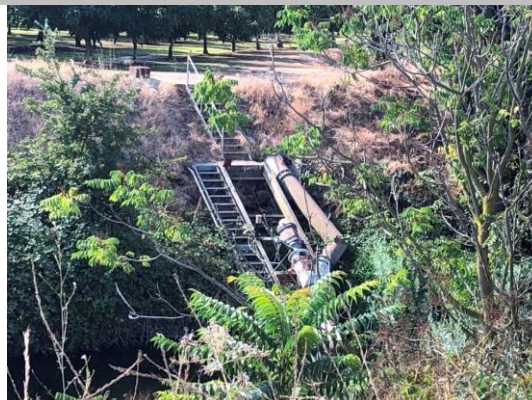
Photo 3 of 3 : SJR2019_NA0017U16RM22.58_3.jpg

Front view of the erosion.

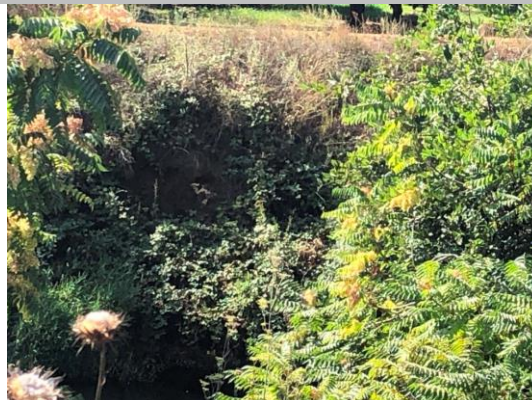
Photo 2 of 2 : SJR2019_NA0017U16RM22.15_2.jpg

Close-up view of the erosion.

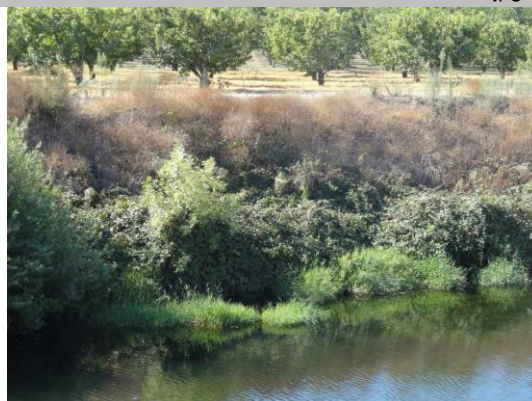
Photo 1 of 3 : SJR2019_NA0017U16RM22.01_2.jpg

Site ID: NA0017U16RM22.01
 08/28/2019: No significant change observed. This area is patrol road only.
 08/30/2017: No significant change observed.
 08/16/2016: No significant change observed.
 08/12/2015: No significant change observed.
 08/20/2014: No significant change observed.
 09/12/2013: No significant change observed.
 08/22/2012: Site is covered with dense vegetation. A scarp erosion is adjacent to a pocket erosion at the downstream. There is no levee structure on site. The levee crest width and levee height were not measured or estimated in the field.

Close-up view of the erosion site.

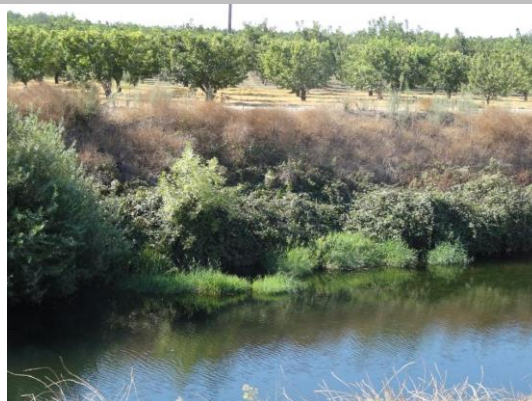
Photo 2 of 3 : SJR2019_NA0017U16RM22.01_4.jpg

Looking at the erosion from the other side of the channel..

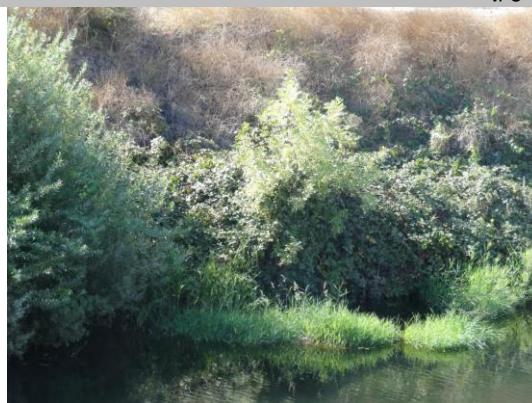
Photo 3 of 3 : SJR2019_NA0017U16RM22.01_3.jpg

Comment Code						
Inspector Comment						
Site ID: NA0017U16RM22.01						
08/28/2019: No significant change observed. This area is patrol road only.						
08/30/2017: No significant change observed.						
08/16/2016: No significant change observed.						
08/12/2015: No significant change observed.						
08/20/2014: No significant change observed.						
09/12/2013: No significant change observed.						
08/22/2012: Site is covered with dense vegetation. A scarp erosion is adjacent to a pocket erosion at the downstream. There is no levee structure on site. The levee crest width and levee height were not measured or estimated in the field.

Close-up view of the pocket erosion. Note the small trees at the site.

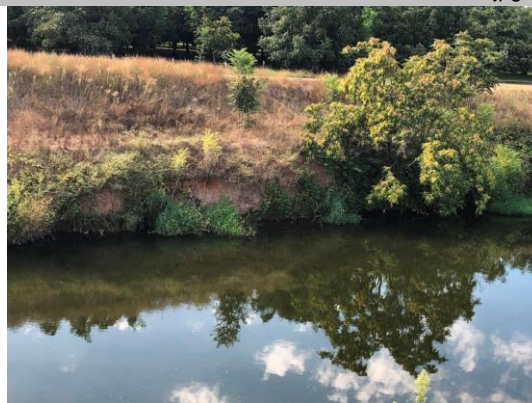
Photo 1 of 3 : SJR2019_NA0017U16RM21.95_1.jpg

LM Start	1.75	Rating **	A/W	Issue No.	76
LM End	1.76	Issue Type +	Ma	Location *	
Category	Supplemental			GPS Latitude/Longitude	
				Start	End
Item	DWR Erosion Survey			38.038080 °	38.038080 °
				-121.038676 °	-121.038676 °
DWR ID	NA0017U16RM21.95				
Comment Code					
Inspector Comment					
Site ID: NA0017U16RM21.95					
08/28/2019: No significant change observed. This area is patrol road only.					
08/30/2017: No significant change observed.					
08/16/2016: No significant change observed.					
08/12/2015: No significant change observed.					
08/20/2014: No significant change observed.					
09/12/2013: No significant change observed.					
08/22/2012: The erosion is covered by dense vegetation. There is no levee structure on site. The levee crest width and levee height were not measured or estimated in the field.

Front view of the erosion site.

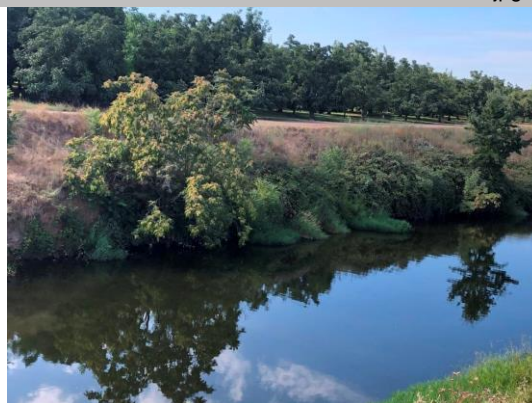
Photo 2 of 3 : SJR2019_NA0017U16RM21.95_2.jpg

Site ID: NA0017U16RM21.95
 08/28/2019: No significant change observed. This area is patrol road only.
 08/30/2017: No significant change observed.
 08/16/2016: No significant change observed.
 08/12/2015: No significant change observed.
 08/20/2014: No significant change observed.
 09/12/2013: No significant change observed.
 08/22/2012: The erosion is covered by dense vegetation. There is no levee structure on site. The levee crest width and levee height were not measured or estimated in the field.

Front view of the erosion.

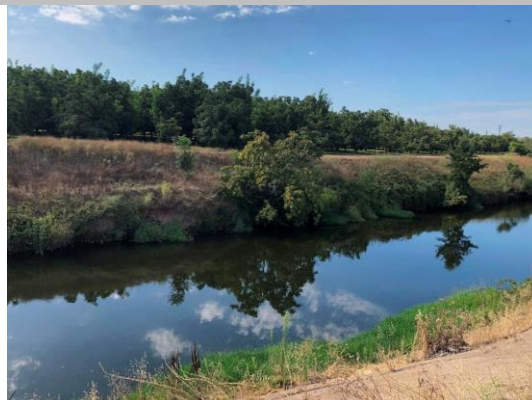
Photo 3 of 3 : SJR2019_NA0017U16RM21.95_3.jpg

Front view of the erosion.

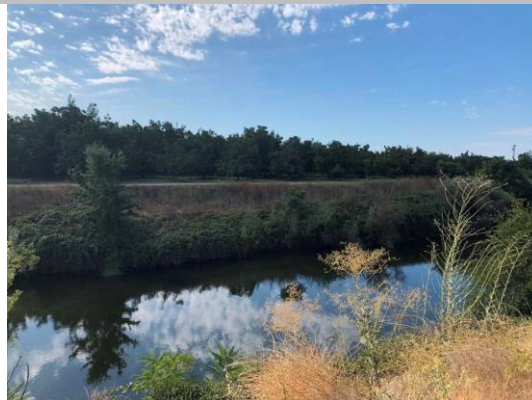
Photo 1 of 3 : SJR2019_NA0017U16RM21.94_1.jpg

08/28/2019: No significant change observed. This area is patrol road only.

08/30/2017: No significant change observed. The site is covered by dense vegetation.

Looking at the erosion from right river bank.

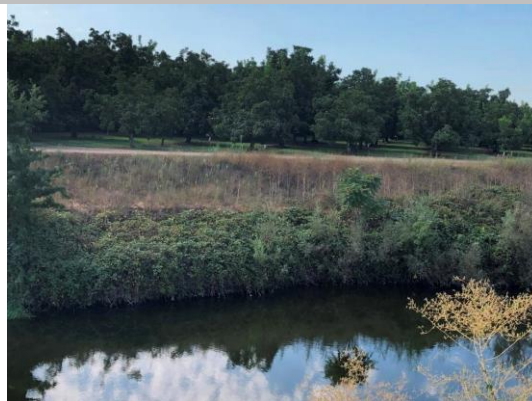
Photo 2 of 3 : SJR2019_NA0017U16RM21.94_2.jpg

Front view of the erosion.

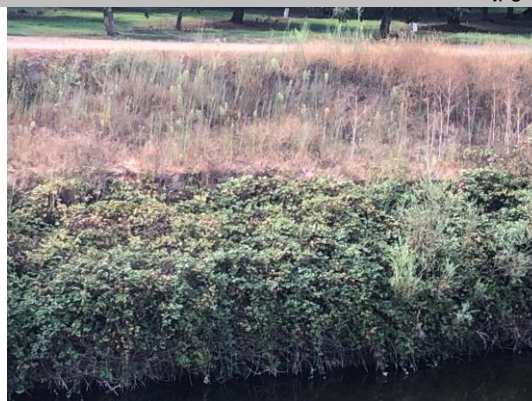
Photo 3 of 3 : SJR2019_NA0017U16RM21.94_3.jpg

Comment Code						
Inspector Comment						
Site ID: NA0017U16RM21.94						
08/28/2019: No significant change observed. This area is patrol road only.						
08/30/2017: No significant change observed. The site is covered by dense vegetation.						
08/16/2016: No significant change observed.						
08/12/2015: No significant change observed.						
08/20/2014: No significant change observed						
09/12/2013: No significant change observed.						
08/22/2012: Site is covered by dense vegetation. Berm width is estimated as 5 ft. There is no levee structure on site. The levee crest width and levee height were not measured or estimated in the field.

Close-up view of the erosion.

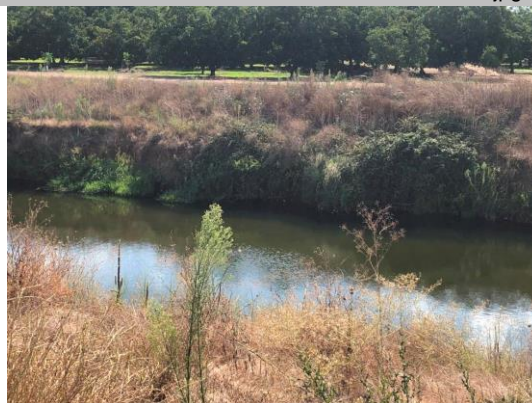
Photo 1 of 3 : SJR2019_NA0017U16RM21.05_1.jpg

LM Start	1.88	Rating **	A/W	Issue No.	74
LM End	1.90	Issue Type +	Ma	Location *	
Category	Supplemental			GPS Latitude/Longitude	
				Start	End
Item	DWR Erosion Survey			38.036549 °	38.036549 °
				-121.040302 °	-121.040302 °
DWR ID	NA0017U16RM21.05				
Comment Code					
Inspector Comment					
Site ID: NA0017U16RM21.05					
08/28/2019: No significant change observed. This area is patrol road only.					
08/30/2017: No significant change observed.					
08/16/2016: No significant change observed.					
08/12/2015: No significant change observed.					
08/20/2014: No significant change observed.					
09/12/2013: No significant change observed.					
08/22/2012: Berm width is estimated as 5 ft. There is no levee structure on site. The levee crest width and levee height were not measured or estimated in the field.

Front view of the erosion

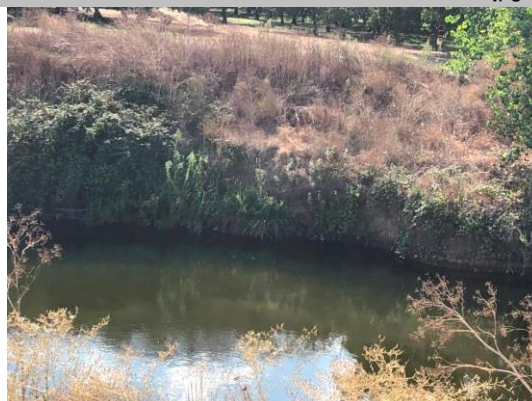
Photo 2 of 3 : SJR2019_NA0017U16RM21.05_3.jpg

Site ID: NA0017U16RM21.05
 08/28/2019: No significant change observed. This area is patrol road only.
 08/30/2017: No significant change observed.
 08/16/2016: No significant change observed.
 08/12/2015: No significant change observed.
 08/20/2014: No significant change observed.
 09/12/2013: No significant change observed.
 08/22/2012: Berm width is estimated as 5 ft. There is no levee structure on site. The levee crest width and levee height were not measured or estimated in the field.

Close-up view of the erosion.

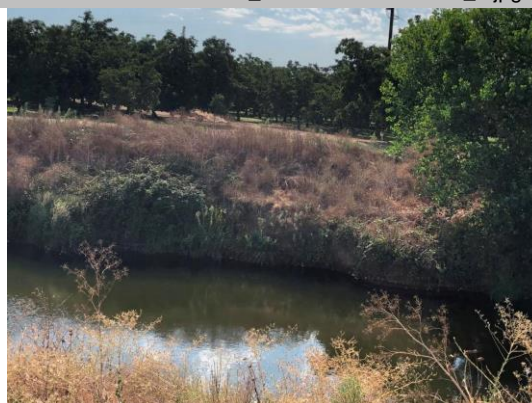
Photo 3 of 3 : SJR2019_NA0017U16RM21.05_2.jpg

Front view of the erosion.

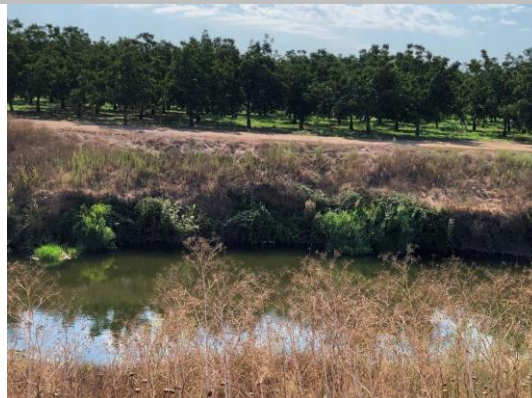
Photo 1 of 3 : SJR2019_DWR_NA0017_16_f_2013_155_2.JPG

LM Start	1.91	Rating **	A/W	Issue No.	72	
LM End	1.91	Issue Type +	Ma	Location *		
Category	Supplemental			GPS Latitude/Longitude		
				Start	End	
Item	DWR Erosion Survey			38.036248 °	38.036248 °	
				-121.040408 °	-121.040408 °	
DWR ID	NA0017U16RM21.03					
Comment Code						
Inspector Comment						
Site ID: NA0017U16RM21.03						
08/28/2019: There is no levee at the site.

Looking at the erosion from the other side of the channel.

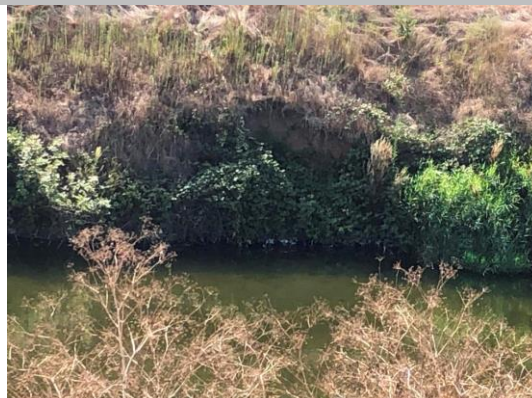
Photo 2 of 3 : SJR2019_DWR_NA0017_16_f_2013_155_1.JPG

Close view of the erosion. Note the dense vegetation at the site.

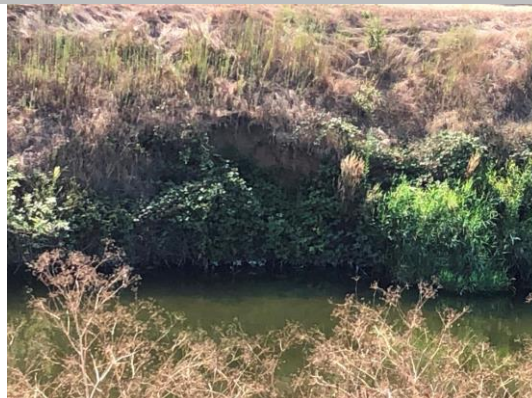
Photo 3 of 3 : SJR2019_DWR_NA0017_16_f_2013_155_3.JPG

Close-up view of the erosion.

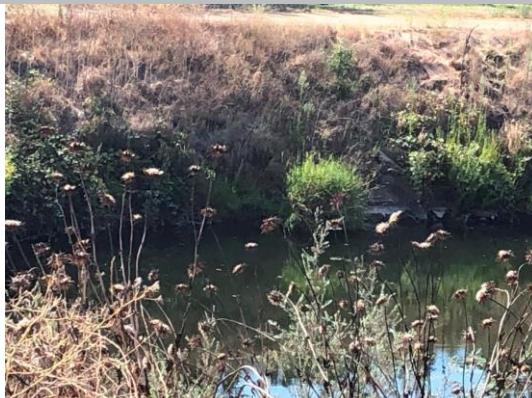
Photo 2 of 3 : SJR2019_NA0017U16RM20.62_2.jpg

Close-up view of the erosion. Note the vegetation at the site.

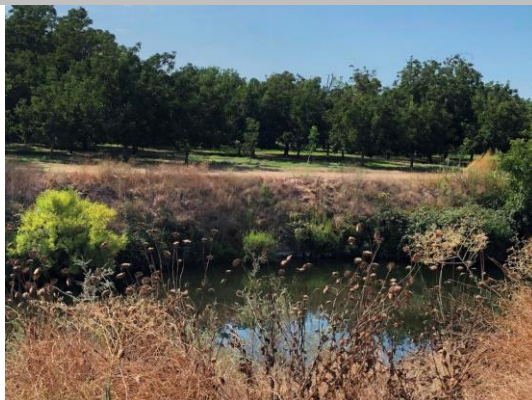
Photo 3 of 3 : SJR2019_NA0017U16RM20.62_3.jpg

Front view of the erosion.

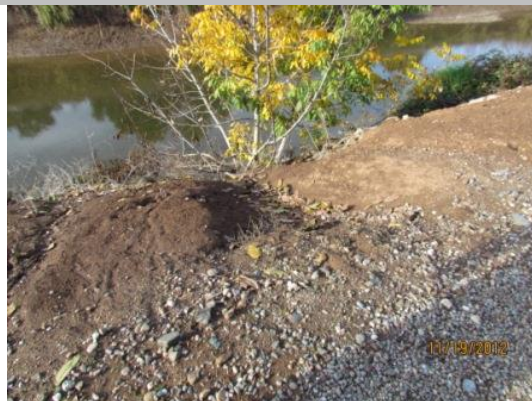
Photo 1 of 2 : FA_2019_NA0017_160_213_20190830_00167.jpg

LM Start	2.35	Rating **	A/W	Issue No.	213
LM End	2.35	Issue Type +	Ma	Location *	WS
Category	Earthen Levee			GPS Latitude/Longitude	
				Start	End
Item	Slope Stability			38.031763 °	38.031763 °
				-121.045808 °	-121.045808 °
DWR ID	DWR_NA0017_16_f_2012_213				
Comment Code					
S1 : Repair slope instability.					
Inspector Comment

Picture of the slope instability on the waterside shoulder of the levee looking upstream.

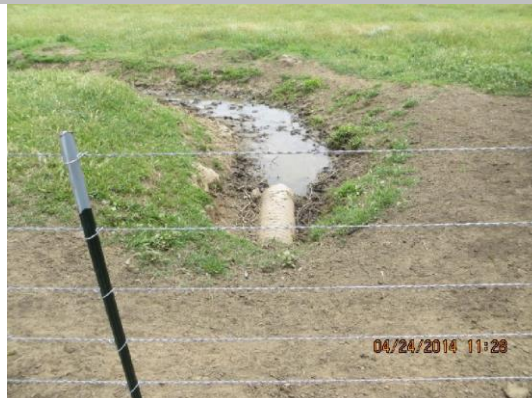
Photo 1 of 2 : UCIP_FA_2019_35551_64000.jpg

LM Start	2.45	Rating **	M	Issue No.	806
LM End	2.45	Issue Type +	Ma	Location *	
Category	Supplemental			GPS Latitude/Longitude	
				Start	End
Item	DRAFT DWR UCIP LMA Responsibility			38.030548 °	38.030548 °
				-121.046998 °	-121.046998 °
DWR ID	23323				
Comment Code					
Inspector Comment					
DS_ID:23323 FS_ID:35551 EP_NO: N/A Repair Type: Non-Urgent Crossing Status: Found UCIP Comments: Heavy vegetation obscuring outlet. remove vegetation and verify flapgate installed. FIELD_STRUCT_DESC: 18-inch corrugated metal drainage pipe, 3 feet below the roadway. Grouted spillway. [Additional Reference(s): DWR Levee Log, 1992. USACE San Joaquin O&M Manual 611.1, Volume F, (HLM 2.52)]. FS Date: 4/24/2014

Pipe visible on LS toe.

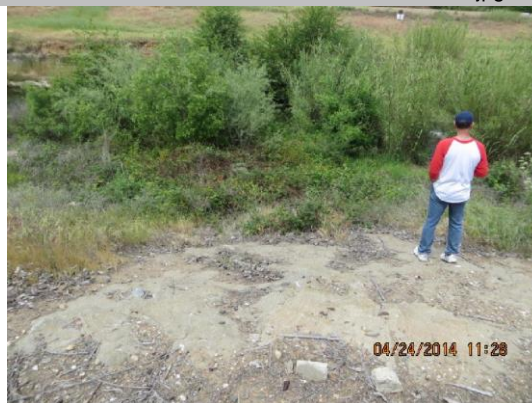
Photo 2 of 2 : UCIP_FA_2019_35551_63999.jpg

Grout over pipe on WS. Heavy vegetation blocking view of outlet.

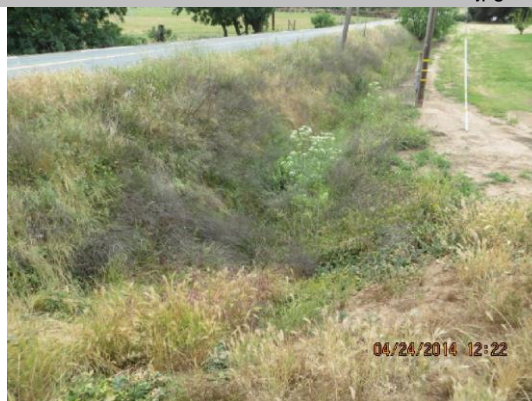
Photo 1 of 3 : UCIP_FA_2019_53506_64067.jpg

Comment Code					
Inspector Comment					
DS_ID:23446 FS_ID:53506 EP_NO: N/A Repair Type: Non-Urgent Crossing Status: Found UCIP Comments: 09/18/2018 Lots of sediment in the inlet: needs to be cleared out. No integrity issues, yet there's dense vegetation and potential flooding risk during high water. Crossing downgraded to "Non-Urgent." (A. McDonald - DWR UCIP)10/31/2016 Same as last inspection. Pipe is open on both ends, no flap gate. (O. Magana - DWR UCIP)04/24/2014 Pipe in non-project levee area. Pipe open on both ends, no flapgate. (W. Wylie - DWR UCIP) FIELD_STRUCT_DESC: 36-inch corrugated metal drainage culvert through the levee, 10 feet below the crown. Pipe open on both ends. [Additional Reference(s): USACE San Joaquin O&M Manual Unit 611, Part No. 1 – Mormon Slough Project, Unit 15 Mormon Slough: HLM 1.18 – 13.46, Unit 15 Diverting Canal: HLM 13.79 – 18.01, Unit 15 Calaveras River LB: 18.54-18.76, Unit 15 Calaveras River RB: HLM 19.35 – 25.38, Unit 16 Mormon Slough: 0.27 – 13.18, Unit 16 Diverting Canal: 14.71 – 17.79, Unit 16 Calaveras River: 18.98 – 23.36, Unit 17 Potter Creek RB: 0.33 – 0.60, Unit 18 Potter Creek LB: 0.00-0.55, (HLM 2.82)] FS Date: 9/18/2018

Pipe inlet on LS toe.

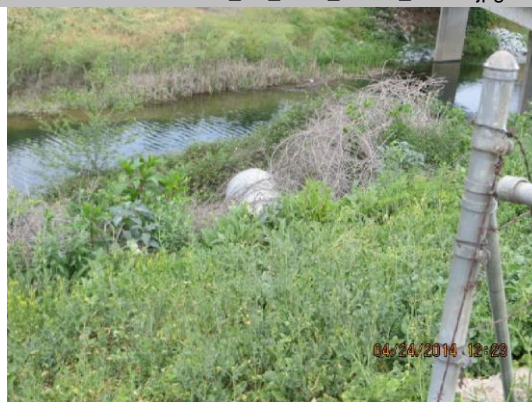
Photo 2 of 3 : UCIP_FA_2019_53506_64066.jpg

Pipe outlet on WS slope.

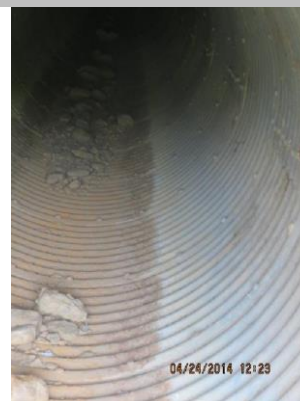
Photo 3 of 3 : UCIP_FA_2019_53506_64065.jpg

Comment Code						
Inspector Comment						
DS_ID:23446						
FS_ID:53506						
EP_NO: N/A						
Repair Type: Non-Urgent						
Crossing Status: Found						
UCIP Comments: 09/18/2018 Lots of sediment in the inlet: needs to be cleared out. No integrity issues, yet there's dense vegetation and potential flooding risk during high water. Crossing downgraded to "Non-Urgent." (A. McDonald - DWR UCIP)10/31/2016 Same as last inspection. Pipe is open on both ends, no flap gate. (O. Magana - DWR UCIP)04/24/2014 Pipe in non-project levee area. Pipe open on both ends, no flapgate. (W. Wylie - DWR UCIP)						
FIELD_STRUCT_DESC: 36-inch corrugated metal drainage culvert through the levee, 10 feet below the crown. Pipe open on both ends.						
[Additional Reference(s): USACE San Joaquin O&M Manual Unit 611, Part No. 1 – Mormon Slough Project, Unit 15 Mormon Slough: HLM 1.18 – 13.46, Unit 15 Diverting Canal: HLM 13.79 – 18.01, Unit 15 Calaveras River LB: 18.54-18.76, Unit 15 Calaveras River RB: HLM 19.35 – 25.38, Unit 16 Mormon Slough: 0.27 – 13.18, Unit 16 Diverting Canal: 14.71 – 17.79, Unit 16 Calaveras River: 18.98 – 23.36, Unit 17 Potter Creek RB: 0.33 – 0.60, Unit 18 Potter Creek LB: 0.00-0.55, (HLM 2.82)]

inside pipe on LS toe.

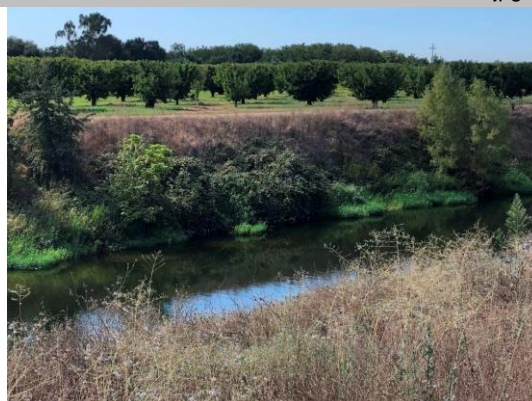
Photo 1 of 3 : SJR2019_NA0017U16RM20.00_1.jpg

Front view of the erosion.

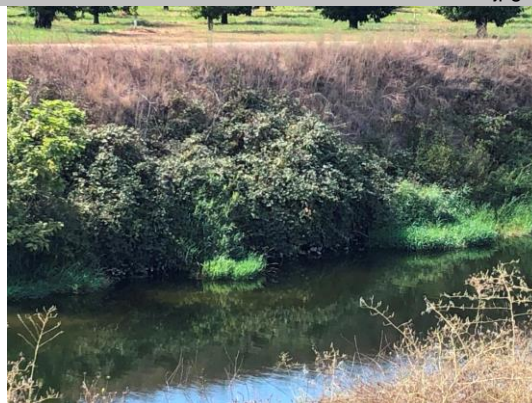
Photo 2 of 3 : SJR2019_NA0017U16RM20.00_2.jpg

Close-up view of the erosion.

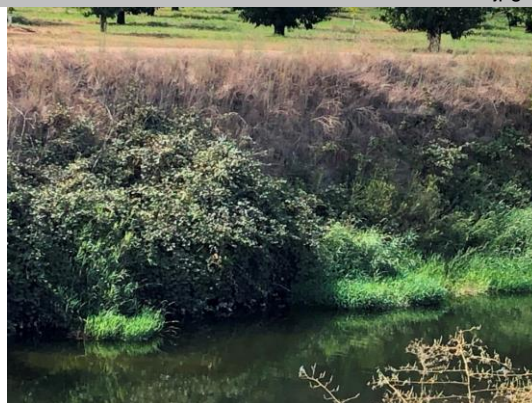
Photo 3 of 3 : SJR2019_NA0017U16RM20.00_3.jpg

Comment Code						
Inspector Comment						
Site ID: NA0017U16RM20						
08/28/2019: No significant change observed. This area is patrol road only.						
08/30/2017: No significant change observed.						
08/16/2016: No significant change observed.						
08/12/2015: No significant change observed.						
08/20/2014: No significant change observed.						
09/12/2013: No significant change observed.						
08/22/2012: Site Comprised of series of pocket and scarp erosions.						
Some of erosions are covered by grass or shrubs. There is no levee structure on site. The levee crest width and levee height were not measured or estimated in the field.

Close-up view of the erosion.

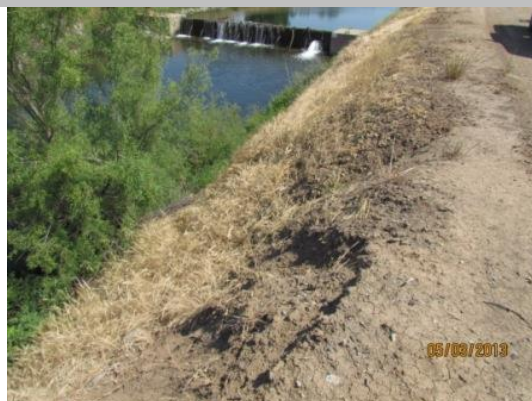
Photo 2 of 2 : FA_2019_NA0017_160_230_20190830_00172.jpg

LM Start	3.53	Rating **	A/W	Issue No.	230 (cont)	
LM End	3.53	Issue Type +	Ma	Location *	WS	
Category	Earthen Levee			GPS Latitude/Longitude		
				Start		End
Item	Erosion / Bank Caving			38.020433 °	38.020433 °	
				-121.061867 °	-121.061867 °	
DWR ID	DWR_NA0017_16_f_2012_230					
Comment Code						
E1 : Note and monitor erosion site.						
Inspector Comment						
This portion of the levee is non-project. Therefore, an A/W rating was given.

Erosion was found on the waterside slope of the levee looking upstream.

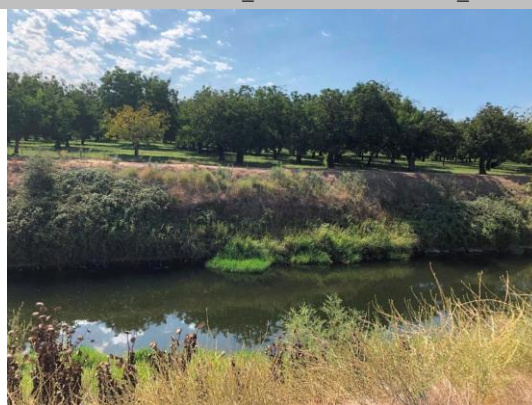
Photo 1 of 3 : SJR2019_NA0017U16RM19.29_1.JPG

LM Start	3.61	Rating **	A/W	Issue No.	60
LM End	3.61	Issue Type +	Ma	Location *	
Category	Supplemental			GPS Latitude/Longitude	
				Start	End
Item	DWR Erosion Survey			38.019642 °	38.019642 °
				-121.062917 °	-121.062917 °
DWR ID	NA0017U16RM19.29				
Comment Code					
Inspector Comment					
Site ID: NA0017U16RM19.29					
08/28/2019: No significant change observed. Patrol road only at this location.					
08/30/2017: No significant change observed.					
08/16/2016: No significant change observed.					
08/12/2015: No significant change observed.					
08/20/2014: A pocket erosion was found near the water's edge.

View of the site from right river bank.

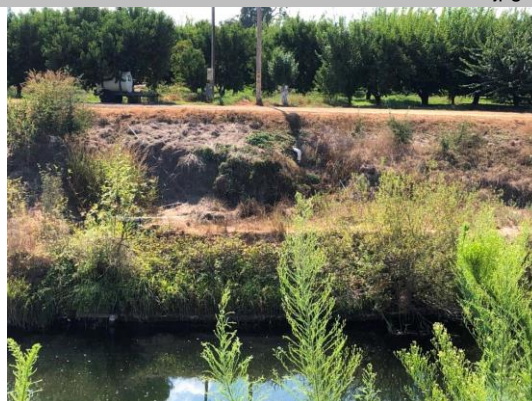
Photo 1 of 3 : SJR2019_NA0017U16RM19.18_1.jpg

Site ID: NA0017U16RM19.18
 08/28/2019: No significant change observed. This area is patrol road only.
 08/30/2017: No significant change observed.
 08/16/2016: No significant change observed at the erosion. More vegetation observed at the site.
 08/12/2015: No significant change observed.
 08/20/2014: No significant change observed.
 09/12/2013: No significant change observed.
 08/22/2012: River-induced erosion occurred on the berm, while the runoff-induced erosion occurred on the levee slope. Site is covered with vegetation. There is no levee structure on site. The levee crest width and levee height were not measured or estimated in the field.

View of the site from right river bank.

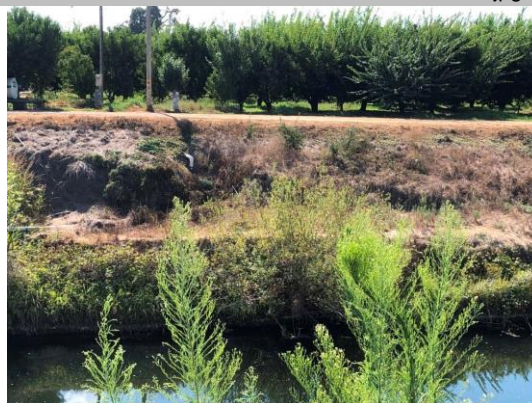
Photo 2 of 3 : SJR2019_NA0017U16RM19.18_2.jpg

Close-up view of the erosion.

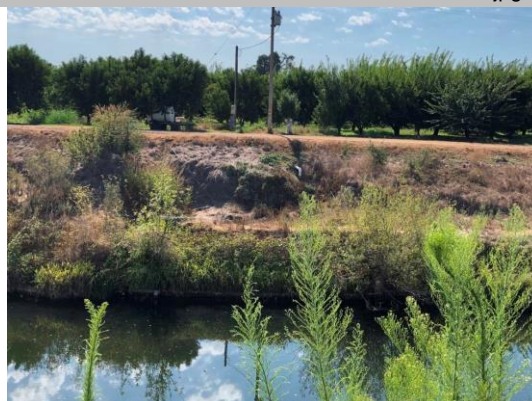
Photo 3 of 3 : SJR2019_NA0017U16RM19.18_5.jpg

Comment Code						
Inspector Comment						
Site ID: NA0017U16RM19.18 08/28/2019: No significant change observed. This area is patrol road only. 08/30/2017: No significant change observed. 08/16/2016: No significant change observed at the erosion. More vegetation observed at the site. 08/12/2015: No significant change observed. 08/20/2014: No significant change observed. 09/12/2013: No significant change observed. 08/22/2012: River-induced erosion occurred on the berm, while the runoff-induced erosion occurred on the levee slope. Site is covered with vegetation. There is no levee structure on site. The levee crest width and levee height were not measured or estimated in the field.

Front view of the erosion at the berm.

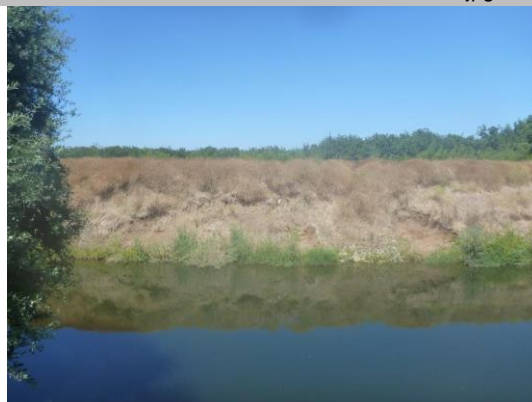
Photo 1 of 3 : LEVAL_FA_2019_475_2258.jpg

LM Start	4.16	Rating **	A/W	Issue No.	242
LM End	4.16	Issue Type +	Ma	Location *	
Category	Supplemental			GPS Latitude/Longitude	
				Start	End
Item	2017 Storm Damage			38.012910 °	38.012910 °
				-121.067996 °	-121.067996 °
DWR ID	LMA-302				
Comment Code					
Inspector Comment					
Levee Evaluation Comments					
Description:Erosion is on the waterside slope; The photo was taken from the right bank. The erosion is on the left bank.					
Site ID No:475					
Site Designation:LMA-302					
Repair Type: Erosion					
Rating:Area of Concern					
Field Date:7/27/2017					
Notes: Small levee prism which turns into high ground nearby. Very dense vegetation on crown (5 ft tall). Opposite bank is lower than the eroded levee and is designed to flood the nearby orchard. This is thought to be caused by a beaver den and has been cited in past 2 DWR inspections.

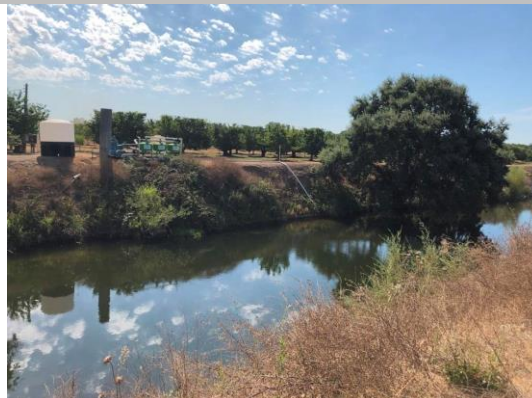
Photo 1 of 3 : SJR2019_NA0017U16RM18.69_1.jpg

08/22/2012: An irrigation pipe is present at the site, but probably did not cause the erosion. There is no levee structure on site. The levee crest width and levee height were not measured or estimated in the field.

View of the erosion site.

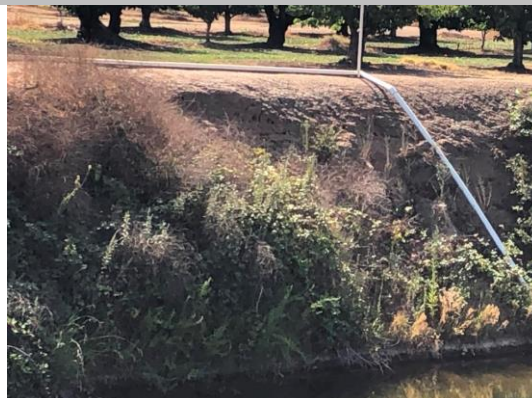
Photo 2 of 3 : SJR2019_NA0017U16RM18.69_3.jpg

08/30/2017: New erosion observed at the site, under the irrigation pipe.

View of the new erosion under the irrigation pipe.

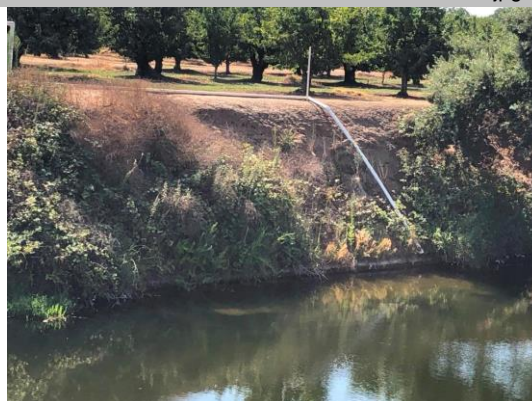
Photo 3 of 3 : SJR2019_NA0017U16RM18.69_2.jpg

Comment Code						
Inspector Comment						
Site ID: NA0017U16RM18.69						
08/28/2019: No significant change observed. This area is patrol road only.						
08/30/2017: New erosion observed at the site, under the irrigation pipe.						
08/16/2016: No significant change observed.						
08/12/2015: No significant change observed.						
08/20/2014: No significant change observed.						
09/12/2013: No significant change observed.						
08/22/2012: An irrigation pipe is present at the site, but probably did not cause the erosion. There is no levee structure on site. The levee crest width and levee height were not measured or estimated in the field.

Close-up view of the erosion.

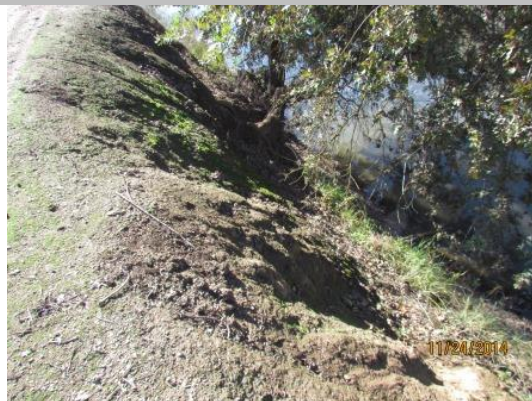
Photo 1 of 2 : FA_2019_NA0017_160_228_20190830_00169.jpg

LM Start	4.20	Rating **	A/W	Issue No.	228
LM End	4.20	Issue Type +	Ma	Location *	WS
Category	Earthen Levee			GPS Latitude/Longitude	
				Start	End
Item	Erosion / Bank Caving			38.012288 °	38.012288 °
				-121.068239 °	-121.068239 °
DWR ID	DWR_NA0017_16_f_2012_228				
Comment Code					
E1 : Note and monitor erosion site.					
Inspector Comment					
This portion of the levee is non-project. Therefore, an A/W rating was given.

Picture of the slope instability on the waterside of the levee looking downstream.

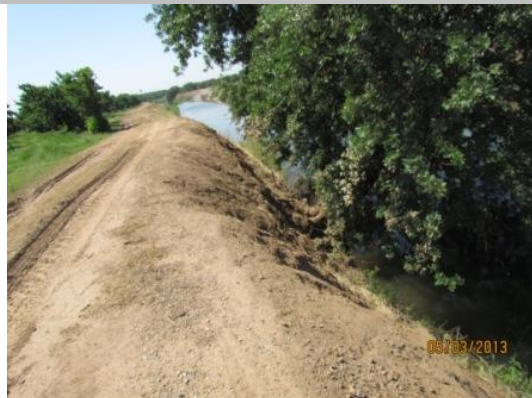
Photo 2 of 2 : FA_2019_NA0017_160_228_20190830_00170.jpg

LM Start	4.20	Rating **	A/W	Issue No.	228 (cont)	
LM End	4.20	Issue Type +	Ma	Location *	WS	
Category	Earthen Levee			GPS Latitude/Longitude		
				Start		End
Item	Erosion / Bank Caving			38.012288 °	38.012288 °	
				-121.068239 °	-121.068239 °	
DWR ID	DWR_NA0017_16_f_2012_228					
Comment Code						
E1 : Note and monitor erosion site.						
Inspector Comment						
This portion of the levee is non-project. Therefore, an A/W rating was given.

Slope instability was found on the waterside shoulder of the levee looking downstream.

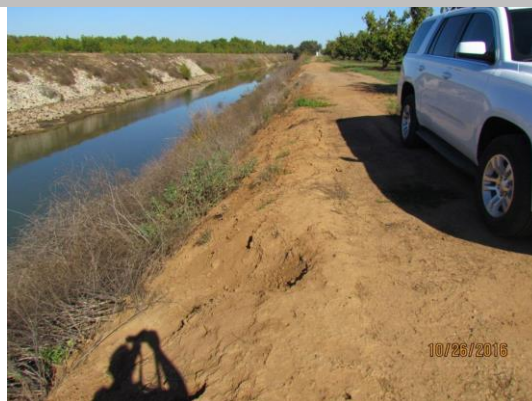
Photo 1 of 1 : FA_2019_NA0017_160_243_20190830_00181.jpg

LM Start	4.38	Rating **	A/W	Issue No.	243
LM End	4.38	Issue Type +	Ma	Location *	WS
Category	Earthen Levee			GPS Latitude/Longitude	
				Start	End
Item	Erosion / Bank Caving			38.009861 °	38.009861 °
				-121.069021 °	-121.069021 °
DWR ID	DWR_NA0017_16_f_2016_243				
Comment Code					
E1 : Note and monitor erosion site.					
Inspector Comment					
The erosion may cut into the access road if it is not repaired.

View of the erosion on the waterside slope of the levee. Fall 2016

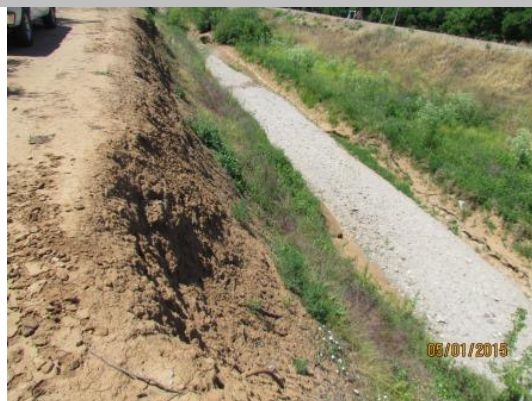
Photo 1 of 1 : FA_2019_NA0017_160_245_20190830_00185.jpg

LM Start	4.85	Rating **	A/W	Issue No.	245
LM End	4.85	Issue Type +	Ma	Location *	WS
Category	Earthen Levee			GPS Latitude/Longitude	
				Start	End
Item	Erosion / Bank Caving			38.003673 °	38.003673 °
				-121.072496 °	-121.072496 °
DWR ID	DWR_NA0017_16_s_2015_245				
Comment Code					
E1 : Note and monitor erosion site.					
Inspector Comment					
Observe to make sure the erosion doesn't cut into the access road.

View of erosion on the waterside slope of the levee looking downstream.

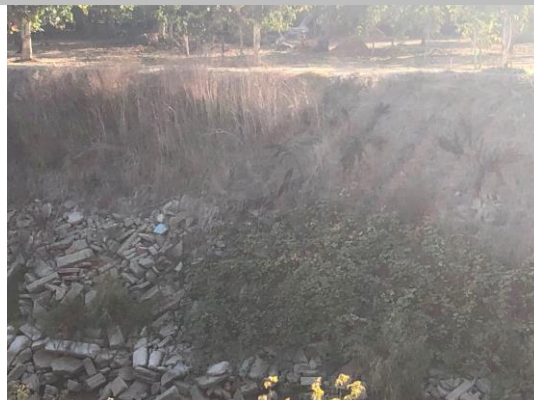
Photo 2 of 3 : SJR2019_NA0017U16RM17.99_3.jpg

Comment Code					
Inspector Comment					
Site ID: NA0017U16RM17.99					
10/29/2019: No new erosion was found at the repaired site. This area is patrol road only.					
08/30/2017: No sign of new erosion observed at the repaired site.					
08/16/2016: This site was repaired recently. No sign of new erosion observed at the repaired site.					
08/12/2015: No significant change observed.					
08/20/2014: No significant change observed.					
09/12/2013: Site has been surveyed and the pocket erosion has developed toward levee crest.					
08/22/2012: A pocket erosion at the levee toe and on lower slope. The levee surface at the upper slope also shows signs of erosion due to poor maintenance. There is no levee structure on site. The levee crest width and levee height were not measured or estimated in the field.

Close-up view of the repaired erosion site.

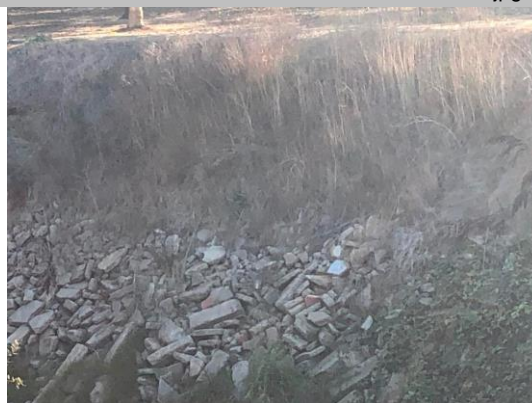
Photo 3 of 3 : SJR2019_NA0017U16RM17.99_4.jpg

Comment Code						
Inspector Comment						
Site ID: NA0017U16RM17.99 10/29/2019: No new erosion was found at the repaired site. This area is patrol road only. 08/30/2017: No sign of new erosion observed at the repaired site. 08/16/2016: This site was repaired recently. No sign of new erosion observed at the repaired site. 08/12/2015: No significant change observed. 08/20/2014: No significant change observed. 09/12/2013: Site has been surveyed and the pocket erosion has developed toward levee crest. 08/22/2012: A pocket erosion at the levee toe and on lower slope. The levee surface at the upper slope also shows signs of erosion due to poor maintenance. There is no levee structure on site. The levee crest width and levee height were not measured or estimated in the field.

Close-up view of the repaired erosion site.

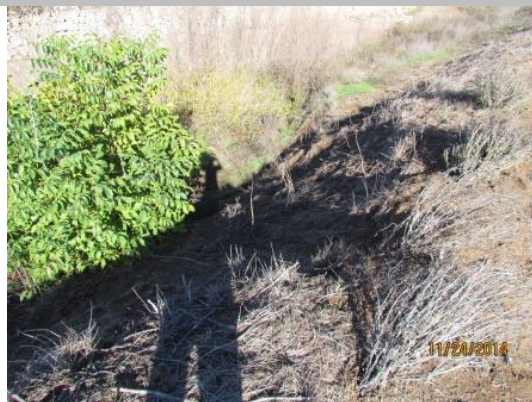
Photo 1 of 1 : FA_2019_NA0017_160_265_20190830_00193.jpg

LM Start	5.20	Rating **	A/W	Issue No.	265
LM End	5.20	Issue Type +	Ma	Location *	WS
Category	Earthen Levee			GPS Latitude/Longitude	
				Start	End
Item	Slope Stability			37.999537 °	37.999537 °
				-121.076133 °	-121.076133 °
DWR ID	DWR_NA0017_16_f_2014_265				
Comment Code					
S1 : Repair slope instability.					
Inspector Comment					
This portion of the levee is non-project. Therefore, an A/W rating was given.

A slope instability was found on the waterside slope of the levee looking upstream.

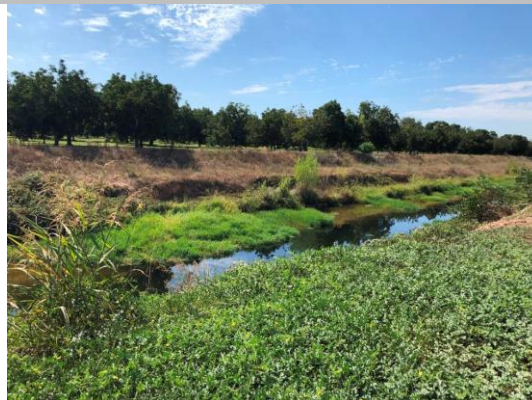
Photo 1 of 3 : SJR2019_NA0017U16RM17.81_1.jpg

Upstream view of the site from right river bank.

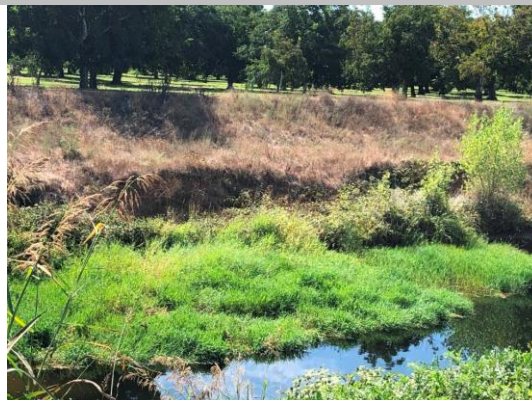
Photo 2 of 3 : SJR2019_NA0017U16RM17.81_2.jpg

Close-up view of the site.

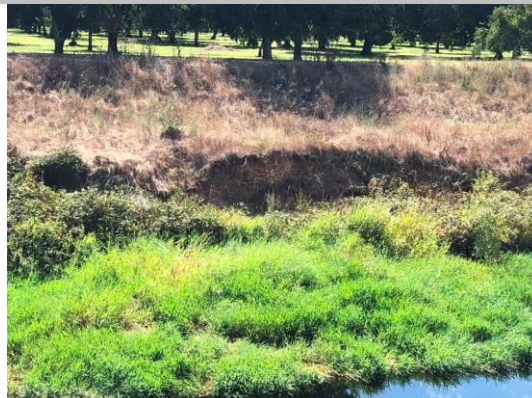
Photo 3 of 3 : SJR2019_NA0017U16RM17.81_3.jpg

LM Start	5.33	Rating **	A/W	Issue No.	46 (cont)	
LM End	5.38	Issue Type +	Ma	Location *		
Category	Supplemental			GPS Latitude/Longitude		
				Start	End	
Item	DWR Erosion Survey			37.997720 °	37.997720 °	
				-121.077807 °	-121.077807 °	
DWR ID	NA0017U16RM17.81					
Comment Code						
Inspector Comment						
Site ID: NA0017U16RM17.81						
08/28/2019: No significant change observed. This area is patrol road only.						
08/30/2017: No significant change observed.						
08/16/2016: No significant change observed.						
08/12/2015: No significant change observed.						
08/20/2014: No significant change observed.						
09/12/2013: No significant change observed.						
08/22/2012: The site is located at the opposite river bank of E. Tobacco Road. There is no levee structure on site. The levee crest width and levee height were not measured or estimated in the field.

Close-up view of the erosion.

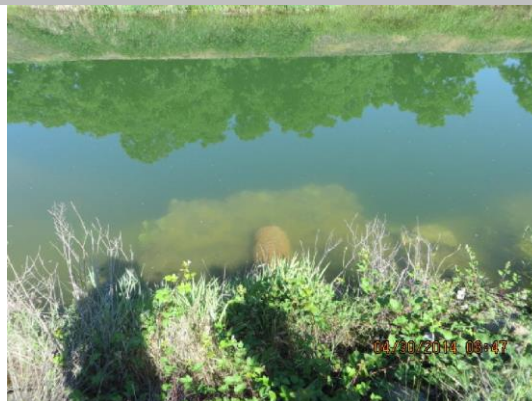
Photo 1 of 3 : UCIP_FA_2019_35686_64327.jpg

Comment Code						
Inspector Comment						
DS_ID:23332						
FS_ID:35686						
EP_NO: N/A						
Repair Type: Non-Urgent						
Crossing Status: Found						
UCIP Comments: Pipe appears abandoned and if so should be done so properly. LS of pipe is buried and WS is badly rusted. Pipe should be inspected internally.						
FIELD_STRUCT_DESC: *ABANDONED* 18-inch corrugated metal drainage pipe through the levee, 3 feet below the crown. Grout over pipe in channel with pipe open and visible in water at the WS toe.						
[Additional Reference(s): DWR Levee Log, 1992. USACE San Joaquin O&M Manual 611.1, Volume F, (HLM 5.69)].						
FS Date: 4/30/2014

Pipe visible in water at WS toe.

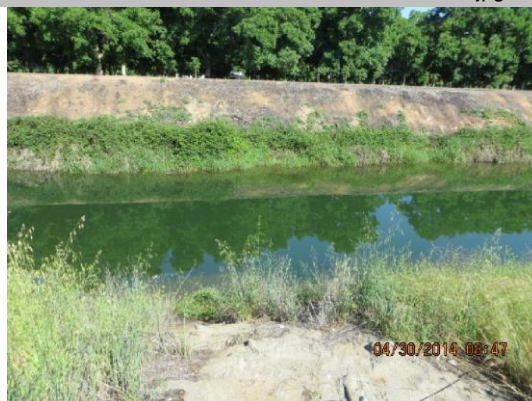
Photo 2 of 3 : UCIP_FA_2019_35686_64326.jpg

Grout over pipe in channel on WS.

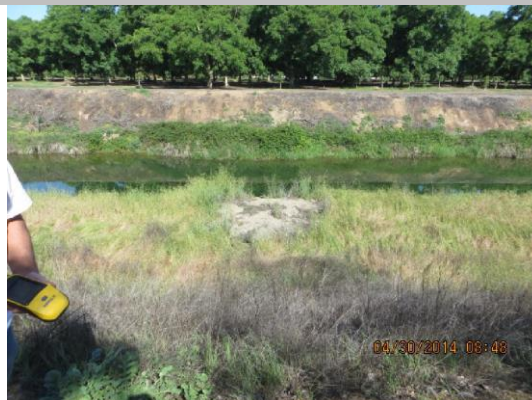
Photo 3 of 3 : UCIP_FA_2019_35686_64325.jpg

Grout over pipe in channel on WS.

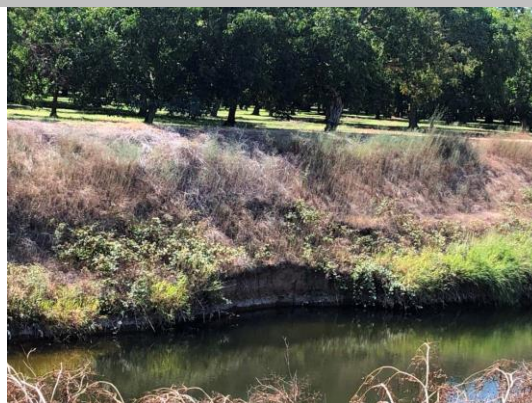
Photo 1 of 3 : SJR2019_NA0017U16RM17.27_1.JPG

LM Start	5.55	Rating **	A/W	Issue No.	42
LM End	5.57	Issue Type +	Ma	Location *	
Category	Supplemental			GPS Latitude/Longitude	
				Start	End
Item	DWR Erosion Survey			37.995216°	37.995216°
				-121.080159°	-121.080159°
DWR ID	NA0017U16RM17.27				
Comment Code					
Inspector Comment					
Site ID: NA0017U16RM17.27					
08/28/2019: No significant change observed. This area is patrol road only.					
08/30/2017: No significant change observed.					
08/16/2016: No significant change observed.					
08/12/2015: No significant change observed.					
08/20/2014: No significant change observed.					
09/12/2013: The erosion seems to be caused by high river flow. Dense vegetation is present at the site. Signs of animal activities are visible.					
There is no levee structure on site. The levee crest width and levee height were not measured or estimated in the field.

View of the erosion from right river bank.

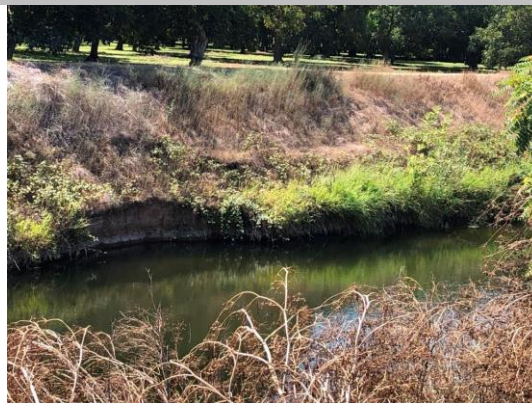
Photo 2 of 3 : SJR2019_NA0017U16RM17.27_2.JPG

Close-up view of the erosion site.

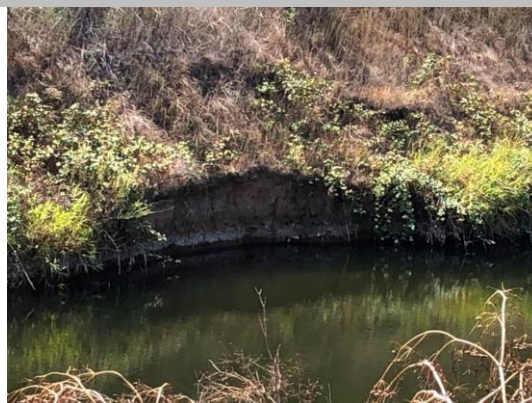
Photo 3 of 3 : SJR2019_NA0017U16RM17.27_3.JPG

LM Start	5.55	Rating **	A/W	Issue No.	42 (cont)	
LM End	5.57	Issue Type +	Ma	Location *		
Category	Supplemental			GPS Latitude/Longitude		
				Start	End	
Item	DWR Erosion Survey			37.995216°	37.995216°	
				-121.080159°	-121.080159°	
DWR ID	NA0017U16RM17.27					
Comment Code						
Inspector Comment						
Site ID: NA0017U16RM17.27						
08/28/2019: No significant change observed. This area is patrol road only.						
08/30/2017: No significant change observed.						
08/16/2016: No significant change observed.						
08/12/2015: No significant change observed.						
08/20/2014: No significant change observed.						
09/12/2013: The erosion seems to be caused by high river flow. Dense vegetation is present at the site. Signs of animal activities are visible.						
There is no levee structure on site. The levee crest width and levee height were not measured or estimated in the field.

Close-up view of the erosion.

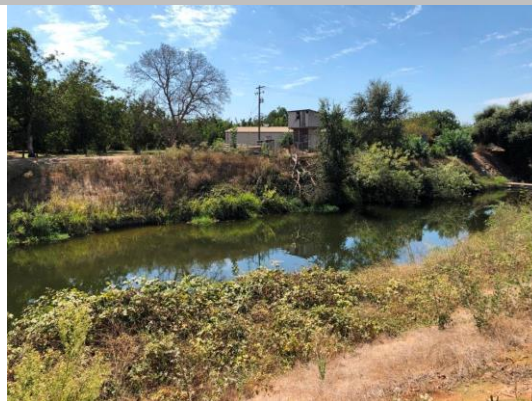
Photo 1 of 3 : SJR2019_NA0017U16RM17.11_1.JPG

LM Start	5.71	Rating **	A/W	Issue No.	41
LM End	5.72	Issue Type +	Ma	Location *	
Category	Supplemental			GPS Latitude/Longitude	
				Start	End
Item	DWR Erosion Survey			37.993525 °	37.993525 °
				-121.081679 °	-121.081679 °
DWR ID	NA0017U16RM17.11				
Comment Code					
Inspector Comment					
Site ID: NA0017U16RM17.11					
08/28/2019: No significant change observed. This area is patrol road only.					
08/30/2017: No significant change observed.					
08/16/2016: No significant change observed.					
08/12/2015: No significant change observed.					
08/20/2014: The erosion is near a tree and probably has been made worse by the unstable bank slope.

View of the site from right river bank.

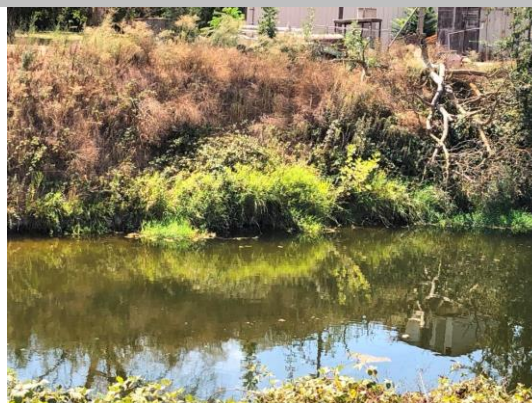
Photo 2 of 3 : SJR2019_NA0017U16RM17.11_2.JPG

Close-up view of the erosion.

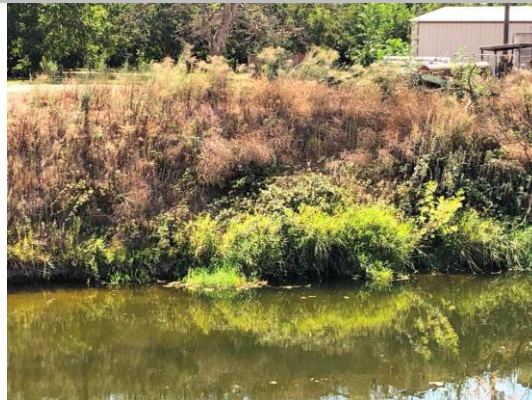
Photo 3 of 3 : SJR2019_NA0017U16RM17.11_3.JPG

Close-up view of the erosion.

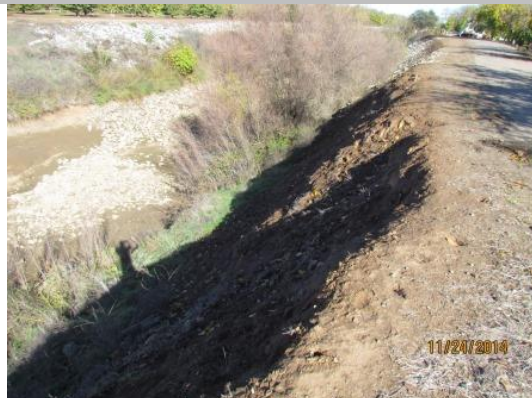
Photo 1 of 1 : FA_2019_NA0017_160_264_20190830_00192.jpg

LM Start	5.87	Rating **	A/W	Issue No.	264
LM End	5.87	Issue Type +	Ma	Location *	WS
Category	Earthen Levee			GPS Latitude/Longitude	
				Start	End
Item	Slope Stability			37.991628 °	37.991628 °
				-121.083312 °	-121.083312 °
DWR ID	DWR_NA0017_16_f_2014_264				
Comment Code					
S1 : Repair slope instability.					
Inspector Comment					
This portion of the levee is non-project. Therefore, an A/W rating was given.

Slope instability was found on the waterside of the levee looking upstream.

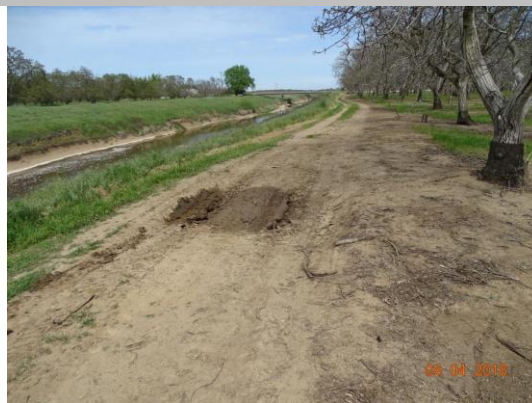
Photo 1 of 1 : FA_2019_NA0017_160_57_20190830_00080.jpg

LM Start	6.45	Rating **	U	Issue No.	57
LM End	6.45	Issue Type +	Ma	Location *	CR
Category	Earthen Levee			GPS Latitude/Longitude	
				Start	End
Item	Crown Surface / Depressions / Rutting			37.984692 °	37.984692 °
				-121.089201 °	-121.089201 °
DWR ID	DWR_NA0017_16_s_2018_57				
Comment Code					
C2 : Repair depressions or ruts in the crown or slope.					
Inspector Comment					
Repair depression to maintain patrol road access.

Repair crown surface looking east.

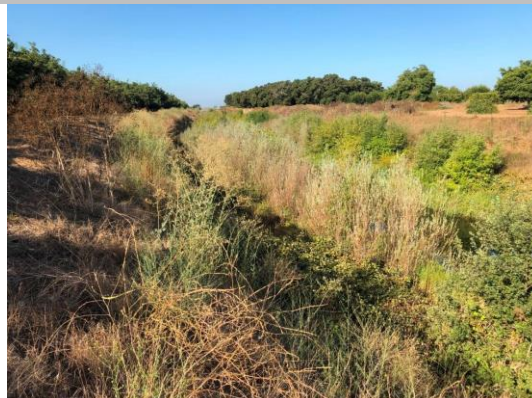
Photo 1 of 3 : SJR2019_NA0017U16RM16.27_1.jpg

Comment Code						
Inspector Comment						
Site ID: NA0017U16RM16.27						
08/29/2019: No significant change observed. This area patrol road only.						
08/30/2017: No significant change observed.						
08/16/2016: No significant change observed.						
08/12/2015: No significant change observed.						
08/20/2014: No significant change observed.						
09/12/2013: Site has been surveyed and the erosion has worsened since last year.						
08/22/2012: Discontinuous scarp or pocket erosions occurred along a long stretch of the river, with an erosion height greater than 25 ft. at certain points. There is no levee structure on site. The levee crest width and levee height were not measured or estimated in the field.

Upstream view of the site from right river bank.

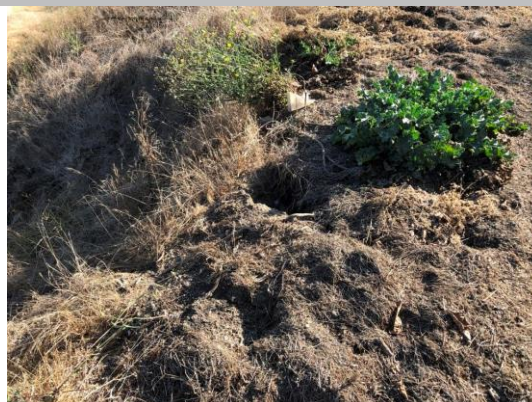
Photo 1 of 3 : SJR2019_DWR_NA0017_16_s_2014_120_3.JPG

LM Start	6.70	Rating **	A/W	Issue No.	39
LM End	6.70	Issue Type +	Ma	Location *	
Category	Supplemental			GPS Latitude/Longitude	
				Start	End
Item	DWR Erosion Survey			37.982299 °	37.982299 °
				-121.092665 °	-121.092665 °
DWR ID	NA0017U16RM16.15				
Comment Code					
Inspector Comment					
Site ID: NA0017U16RM16.15					
08/29/2019: There is no levee at the site. The erosion is likely caused by the rainfall runoff.

Looking at the erosion from the bank top.

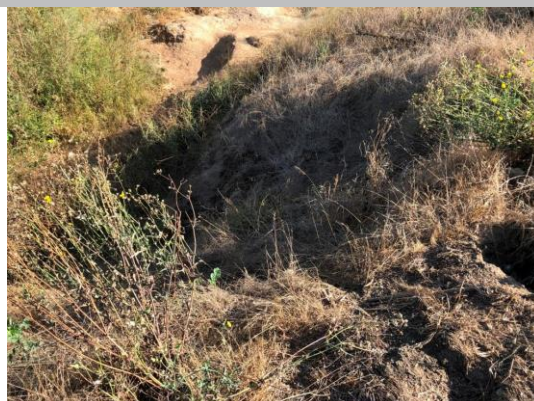
Photo 2 of 3 : SJR2019_DWR_NA0017_16_s _ 2014_120_2.JPG

LM Start	6.70	Rating **	A/W	Issue No.	39 (cont)	
LM End	6.70	Issue Type +	Ma	Location *		
Category	Supplemental			GPS Latitude/Longitude		
				Start	End	
Item	DWR Erosion Survey			37.982299 °	37.982299 °	
				-121.092665 °	-121.092665 °	
DWR ID	NA0017U16RM16.15					
Comment Code						
Inspector Comment						
Site ID: NA0017U16RM16.15						
08/29/2019: There is no levee at the site. The erosion is likely caused by the rainfall runoff.

Close view of the erosion. Note the dense vegetation at the site.

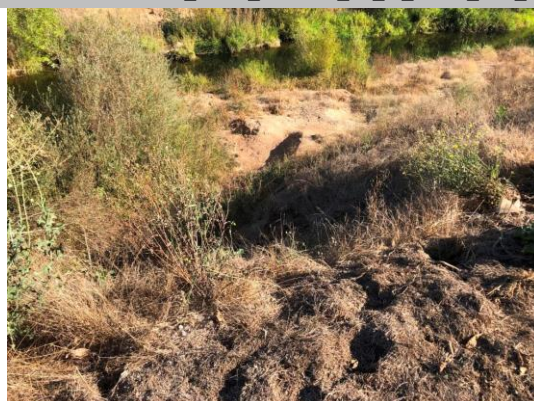
Photo 3 of 3 : SJR2019_DWR_NA0017_16_s _ 2014_120_5.JPG

Close-up view of the erosion. Note the animal activities at the site.

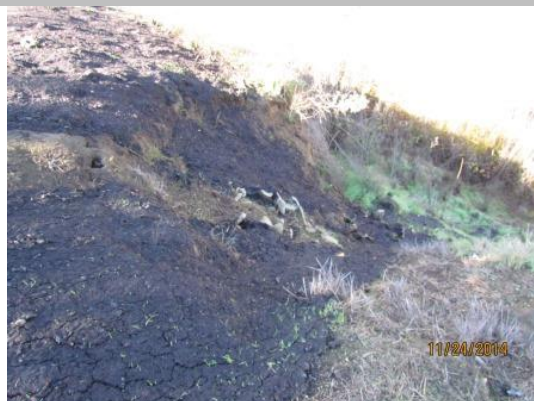
Photo 1 of 2 : FA_2019_NA0017_160_120_20190830_00145.jpg

LM Start	6.70	Rating **	A/W	Issue No.	120
LM End	6.70	Issue Type +	Ma	Location *	WS
Category	Earthen Levee			GPS Latitude/Longitude	
				Start	End
Item	Slope Stability			37.982299 °	37.982299 °
				-121.092665 °	-121.092665 °
DWR ID	DWR_NA0017_16_s _ 2014_120				
Comment Code					
S1 : Repair slope instability.					
Inspector Comment					
This portion of the levee is non-project. Therefore, an A/W rating was given.

Updated picture of the slope instability on the waterside of the levee looking downstream.
