**Flood Control Project Maintenance
Levee Inspections**

Maintenance Issue Types Only, Levee Inspection Report By Mile - Fall 2019

San Joaquin County Flood Control and Water Conservation District

Waterway	Bank	Unit Miles	Inspection Start/End	Inspector
Unit No. 01 Littlejohn Creek	Left	2.59	11/14/2019 11/14/2019	Alberto De Leon

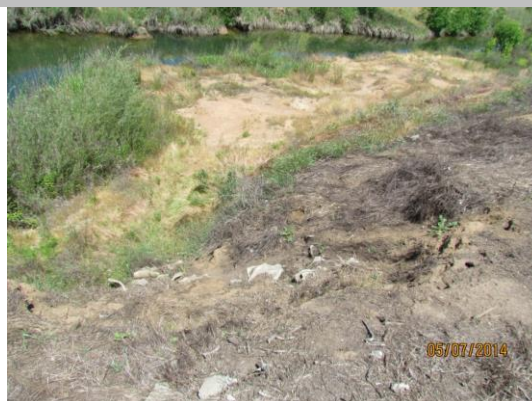
Photo 2 of 2 : FA_2019_NA0017_160_120_20190830_00146.jpg

LM Start	6.70	Rating **	A/W	Issue No.	120 (cont)	
LM End	6.70	Issue Type +	Ma	Location *	WS	
Category	Earthen Levee			GPS Latitude/Longitude		
				Start		End
Item	Slope Stability			37.982299 °		37.982299 °
				-121.092665 °		-121.092665 °
DWR ID	DWR_NA0017_16_s_2014_120					
Comment Code						
S1 : Repair slope instability.						
Inspector Comment						
This portion of the levee is non-project. Therefore, an A/W rating was given.

Slope instability was found on the waterside of the levee looking upstream.

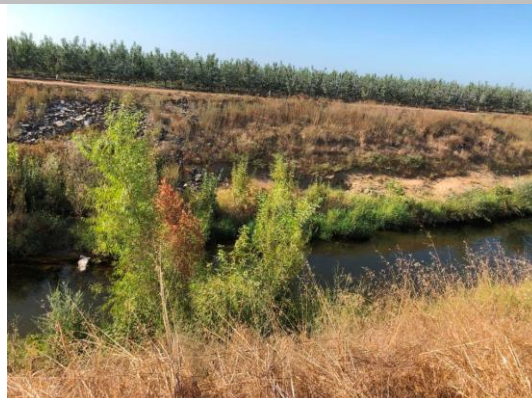
Photo 1 of 3 : SJR2019_NA0017U16RM15.57_1.JPG

Comment Code					
Inspector Comment					
Site ID: NA0017U16RM15.57 08/29/2019: No significant change observed. This area is patrol road only. 08/30/2017: No significant change observed. 08/16/2016: No significant change observed. 08/12/2015: No significant change observed. 08/20/2014: No significant change observed. Note the site ID changed from NA0017U16RM10.82 to NA0017U16RM15.57 to reflect the correct river mile. 09/12/2013: The site is located at immediately downstream of a levee segment protected by broken concrete. There is no levee structure on site. The levee crest width and levee height were not measured or estimated in the field.

View of the site from right river bank.

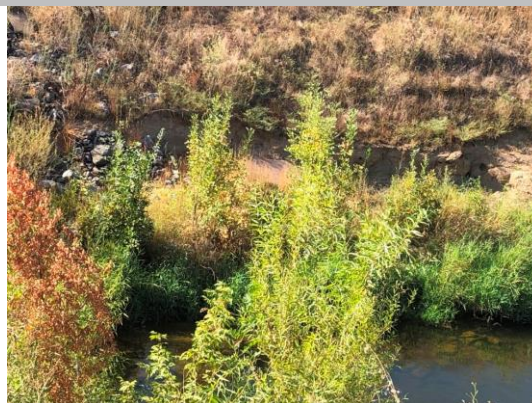
Photo 2 of 3 : SJR2019_NA0017U16RM15.57_2.JPG

Close-up view of the erosion.

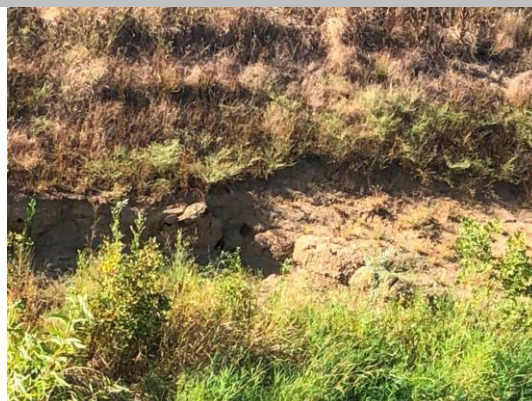
Photo 3 of 3 : SJR2019_NA0017U16RM15.57_4.JPG

Comment Code						
Inspector Comment						
Site ID: NA0017U16RM15.57 08/29/2019: No significant change observed. This area is patrol road only. 08/30/2017: No significant change observed. 08/16/2016: No significant change observed. 08/12/2015: No significant change observed. 08/20/2014: No significant change observed. Note the site ID changed from NA0017U16RM10.82 to NA0017U16RM15.57 to reflect the correct river mile. 09/12/2013: The site is located at immediately downstream of a levee segment protected by broken concrete. There is no levee structure on site. The levee crest width and levee height were not measured or estimated in the field.

Close-up view of the erosion.

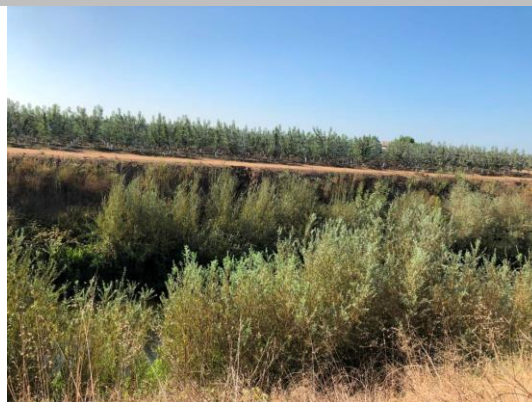
Photo 1 of 3 : SJR2019_DWR_NA0017_16_f_2015_237_1.JPG

LM Start	7.42	Rating **	A/W	Issue No.	37	
LM End	7.43	Issue Type +	Ma	Location *		
Category	Supplemental			GPS Latitude/Longitude		
				Start		End
Item	DWR Erosion Survey			37.977421 °		37.977421 °
				-121.103507 °		-121.103507 °
DWR ID	NA0017U16RM15.45					
Comment Code						
Inspector Comment						
Site ID: NA0017U16RM15.45						
08/28/2019: This area is patrol road only.

Looking at the erosion from other side of the channel.

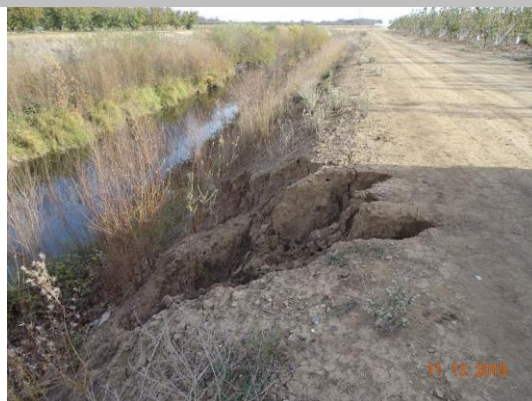
Photo 2 of 2 : FA_2019_NA0017_160_259_20191118_00447.jpg

LM Start	7.43	Rating **	U	Issue No.	259 (cont)	
LM End	7.43	Issue Type +	Ma	Location *	WS	
Category	Earthen Levee			GPS Latitude/Longitude		
				Start		End
Item	Erosion / Bank Caving			37.977285 °		37.977285 °
				-121.103735 °		-121.103735 °
DWR ID	DWR_NA0017_16_f_2019_259					
Comment Code						
E2 : Schedule repair of erosion site prior to the next inspection.						
Inspector Comment						
Waterside bank erosion caused by surface runoff may cut into patrol access road.

View of erosion/bank caving on waterside bank. Fall 2019

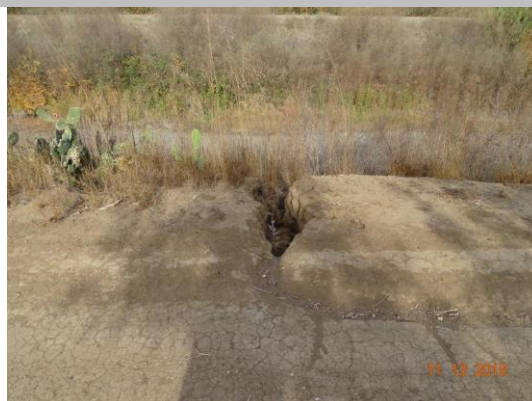
Photo 1 of 2 : FA_2019_NA0017_160_275_20191118_00450.jpg

LM Start	7.84	Rating **	M	Issue No.	275
LM End	7.84	Issue Type +	Ma	Location *	WS
Category	Earthen Levee			GPS Latitude/Longitude	
				Start	End
Item	Erosion / Bank Caving			37.973620 °	37.973620 °
				-121.109680 °	-121.109680 °
DWR ID	DWR_NA0017_16_s_2016_275				
Comment Code					
E2 : Schedule repair of erosion site prior to the next inspection.					
Inspector Comment					
Erosion may cut into the access road.

View of erosion/bank caving on waterside bank. Fall 2019

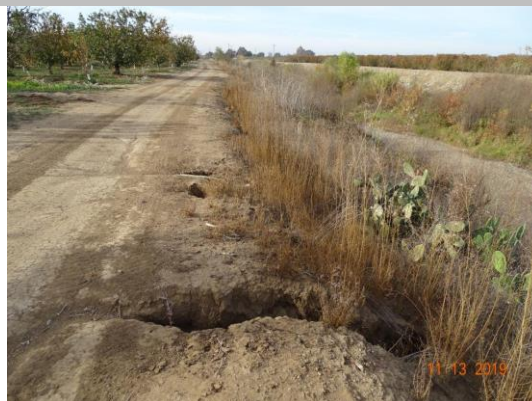
Photo 2 of 2 : FA_2019_NA0017_160_275_20191118_00451.jpg

View of erosion/bank caving on waterside bank. Fall 2019

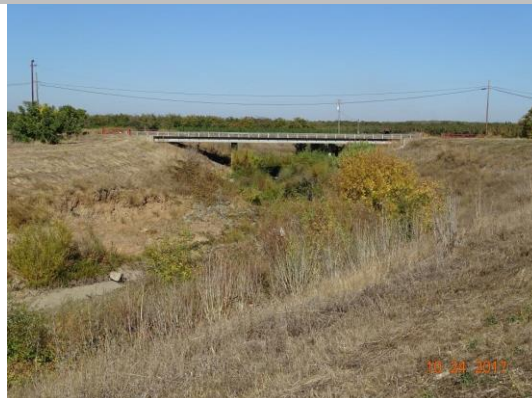
Photo 1 of 1 : FA_2019_NA0017_160_255_20190830_00190.jpg

LM Start	8.17	Rating **	M	Issue No.	255
LM End	8.17	Issue Type +	Ma	Location *	WS
Category	Rivers, Channels & Designated Floodways			GPS Latitude/Longitude	
				Start	End
Item	Vegetation & Obstructions			37.970427 °	37.970427 °
				-121.113623 °	-121.113623 °
DWR ID	DWR_NA0017_16_f_2017_255				
Comment Code					
Inspector Comment					
Woody vegetation may impede the flow of the channel at this location.

View of woody vegetation on the channel looking upstream. Fall 2017

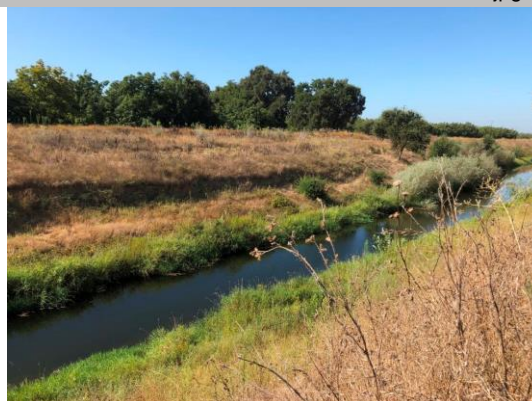
Photo 1 of 3 : SJR2019_NA0017U16RM14.48_1.jpg

Comment Code						
Inspector Comment						
Site ID: NA0017U16RM14.48						
08/29/2019: No significant change observed. This area is patrol road only.						
08/30/2017: No significant change observed.						
08/16/2016: No significant change observed.						
08/12/2015: No significant change observed.						
08/20/2014: No significant change observed.						
09/12/2013: No significant change observed.						
08/22/2012: The erosion occurred on a berm of approximately 25 ft. wide. Site is covered with dense vegetation. There is no levee structure on site. The levee crest width and levee height were not measured or estimated in the field.

View of the site from right river bank.

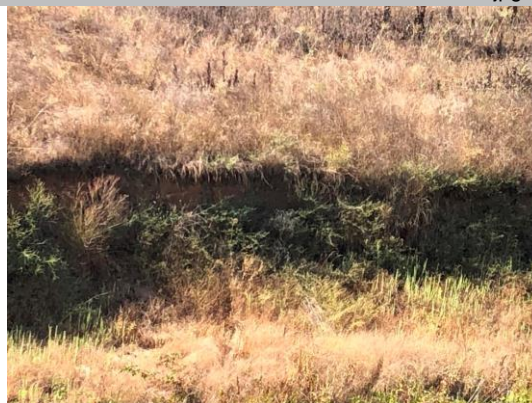
Photo 3 of 3 : SJR2019_NA0017U16RM14.48_3.jpg

Close-up view of the erosion.

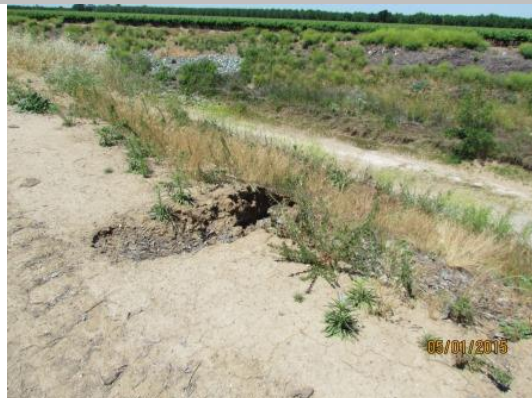
Photo 1 of 1 : FA_2019_NA0017_160_248_20190830_00187.jpg

LM Start	8.68	Rating **	M	Issue No.	248
LM End	8.68	Issue Type +	Ma	Location *	WS
Category	Earthen Levee			GPS Latitude/Longitude	
				Start	End
Item	Erosion / Bank Caving			37.968169 °	37.968169 °
				-121.122047 °	-121.122047 °
DWR ID	DWR_NA0017_16_s_2015_248				
Comment Code					
E1 : Note and monitor erosion site.					
Inspector Comment					
Erosion may cut into the access road.

Erosion was found on the waterside looking downstream.

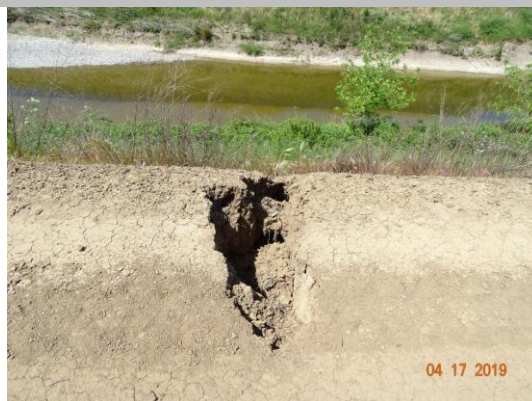
Photo 1 of 1 : FA_2019_NA0017_160_294_20190830_00205.jpg

LM Start	8.88	Rating **	U	Issue No.	294
LM End	8.88	Issue Type +	Ma	Location *	WS
Category	Earthen Levee			GPS Latitude/Longitude	
				Start	End
Item	Animal Control			37.966615 °	37.966615 °
				-121.125125 °	-121.125125 °
DWR ID	DWR_NA0017_16_s_2019_294				
Comment Code					
A3 : No rodents visible, but rodent burrows visible; need to backfill and compact or grout burrows.					
Inspector Comment					
The bank caving is approximately 1.5' wide by 1.5' deep by 6' long. This caving appears to be related to rodent activity and may cut into the patrol access road.

View of burrow hole on waterside shoulder. (Spring 2019)

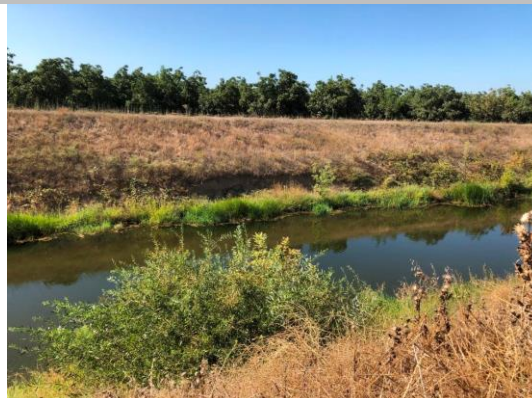
Photo 1 of 3 : SJR2019_NA0017U16RM13.86_1.jpg

Site ID: NA0017U16RM13.86
 08/29/2019: No significant change observed. This area is patrol road only.
 08/30/2017: No significant change observed.
 08/16/2016: No significant change observed.
 08/12/2015: No significant change observed.
 08/20/2014: No significant change observed.
 09/12/2013: No significant change observed.
 08/22/2012: Pocket erosion at the levee toe and slope. The erosion is covered with dense vegetation. There is no levee structure on site. The levee crest width and levee height were not measured or estimated in the field.

Front view of the erosion.

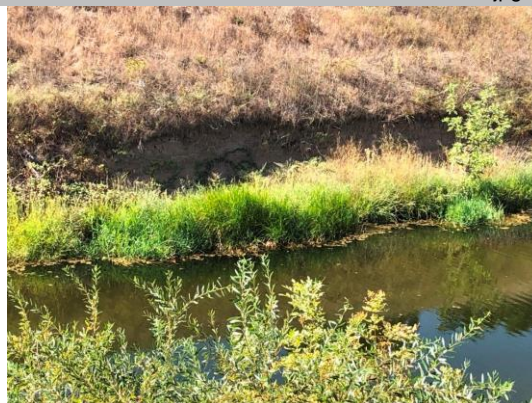
Photo 2 of 3 : SJR2019_NA0017U16RM13.86_2.jpg

Close-up view of the erosion.

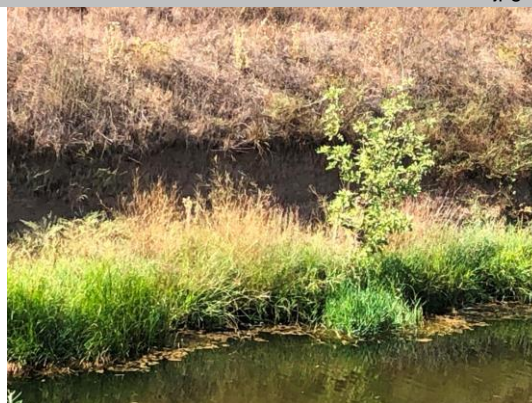
Photo 3 of 3 : SJR2019_NA0017U16RM13.86_4.jpg

LM Start	8.99	Rating **	A/W	Issue No.	27 (cont)	
LM End	8.99	Issue Type +	Ma	Location *		
Category	Supplemental			GPS Latitude/Longitude		
				Start	End	
Item	DWR Erosion Survey			37.966644 °	37.966644 °	
				-121.125932 °	-121.125932 °	
DWR ID	NA0017U16RM13.86					
Comment Code						
Inspector Comment						
Site ID: NA0017U16RM13.86						
08/29/2019: No significant change observed. This area is patrol road only.						
08/30/2017: No significant change observed.						
08/16/2016: No significant change observed.						
08/12/2015: No significant change observed.						
08/20/2014: No significant change observed.						
09/12/2013: No significant change observed.						
08/22/2012: Pocket erosion at the levee toe and slope. The erosion is covered with dense vegetation. There is no levee structure on site. The levee crest width and levee height were not measured or estimated in the field.

Close-up view of the erosion.

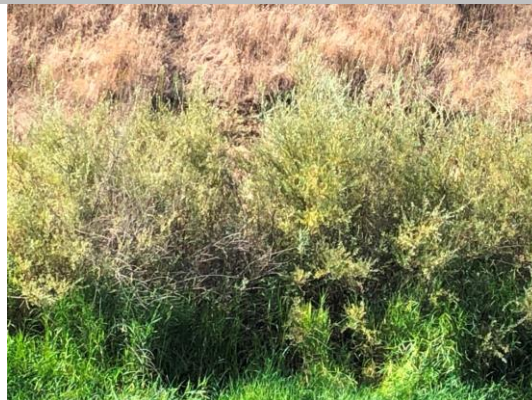
Photo 2 of 3 : SJR2019_NA0017U16RM13.85_2.JPG

Close-up view of the erosion.

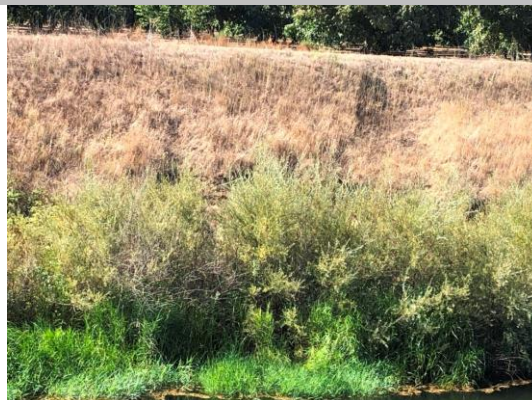
Photo 3 of 3 : SJR2019_NA0017U16RM13.85_3.JPG

Close-up view of the erosion.

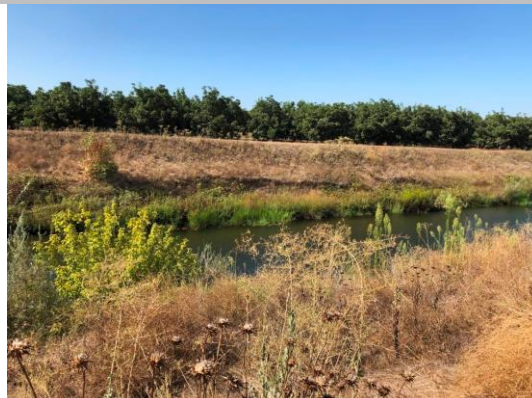
Photo 1 of 3 : SJR2019_NA0017U16RM13.72_1.jpg

Site ID: NA0017U16RM13.72
 08/29/2019: No significant change observed.
 08/30/2017: No significant change observed.
 08/16/2016: No significant change observed.
 08/12/2015: No significant change observed.
 08/20/2014: No significant change observed.
 09/12/2013: No significant change observed.
 08/22/2012: The erosion is covered with dense vegetation. There is no levee structure on site. The levee crest width and levee height were not measured or estimated in the field.

Upstream view of the erosion.

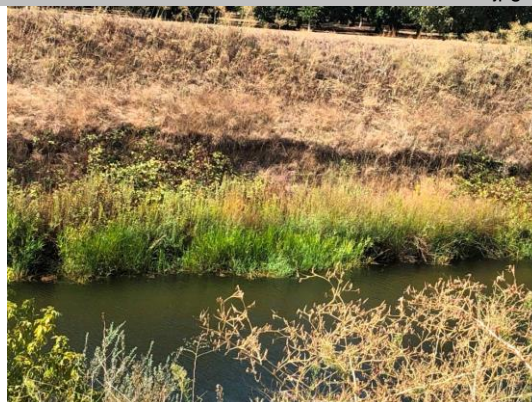
Photo 2 of 3 : SJR2019_NA0017U16RM13.72_2.jpg

Close-up view of the erosion.

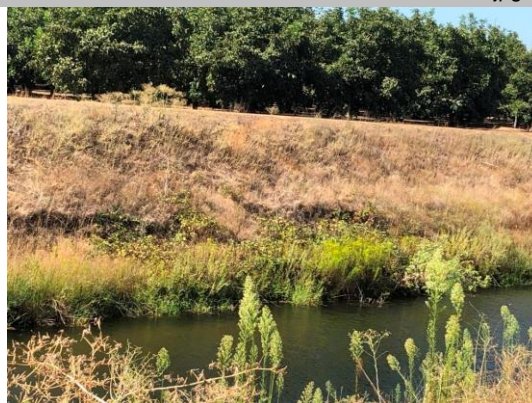
Photo 3 of 3 : SJR2019_NA0017U16RM13.72_3.jpg

LM Start	9.11	Rating **	A/W	Issue No.	18 (cont)	
LM End	9.13	Issue Type +	Ma	Location *		
Category	Supplemental			GPS Latitude/Longitude		
				Start	End	
Item	DWR Erosion Survey			37.966922 °	37.966922 °	
				-121.129533 °	-121.129533 °	
DWR ID	NA0017U16RM13.72					
Comment Code						
Inspector Comment						
Site ID: NA0017U16RM13.72 08/29/2019: No significant change observed. 08/30/2017: No significant change observed. 08/16/2016: No significant change observed. 08/12/2015: No significant change observed. 08/20/2014: No significant change observed. 09/12/2013: No significant change observed. 08/22/2012: The erosion is covered with dense vegetation. There is no levee structure on site. The levee crest width and levee height were not measured or estimated in the field.

Close-up view of the erosion.

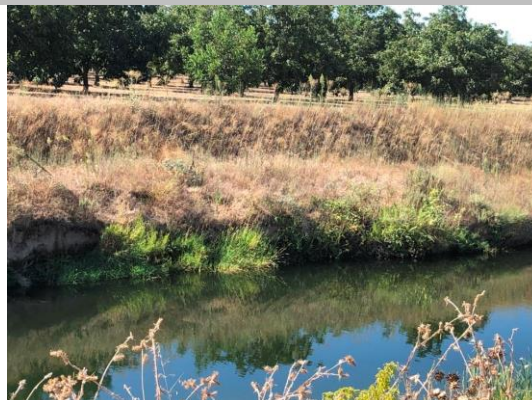
Photo 3 of 3 : SJR2019_NA0017U16RM13.53_3.jpg

Close-up view of the erosion.

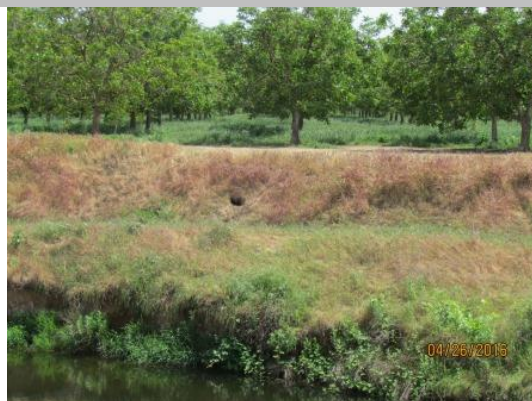
Photo 1 of 1 : FA_2019_NA0017_160_304_20190830_00209.jpg

LM Start	9.33	Rating **	A/W	Issue No.	304
LM End	9.33	Issue Type +	Ma	Location *	WS
Category	Earthen Levee			GPS Latitude/Longitude	
				Start	End
Item	Animal Control			37.966739 °	37.966739 °
				-121.133254 °	-121.133254 °
DWR ID	DWR_NA0017_16_s_2016_304				
Comment Code					
A3 : No rodents visible, but rodent burrows visible; need to backfill and compact or grout burrows.					
Inspector Comment

View of a rodent hole possible made by a coyote on the waterside slope of the levee. The picture was taken from the opposite side of the levee.

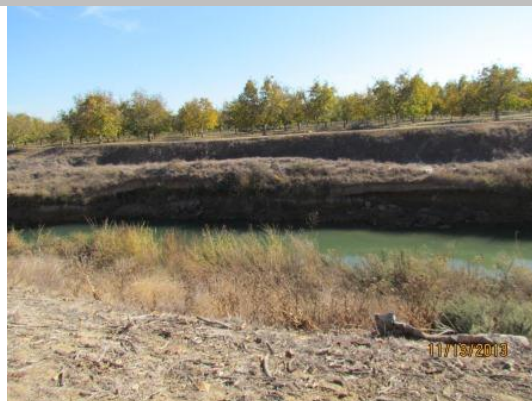
Photo 1 of 1 : FA_2019_NA0017_160_28_20190830_00026.jpg

LM Start	9.48	Rating **	A/W	Issue No.	28
LM End	9.48	Issue Type +	Ma	Location *	WS
Category	Earthen Levee			GPS Latitude/Longitude	
				Start	End
Item	Erosion / Bank Caving			37.966239 °	37.966239 °
				-121.136172 °	-121.136172 °
DWR ID	DWR_NA0017_16_f_2013_28				
Comment Code					
E2 : Schedule repair of erosion site prior to the next inspection.					
Inspector Comment					
Erosion was found on the waterside toe of the levee.

View of the erosion on the waterside toe of the levee looking from the opposite side of the levee.

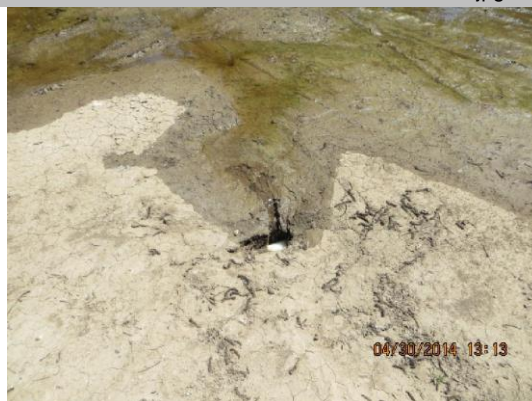
Photo 1 of 3 : UCIP_FA_2019_36144_65406.jpg

LM Start	9.48	Rating **	M	Issue No.	829
LM End	9.48	Issue Type +	Ma	Location *	
Category	Supplemental			GPS Latitude/Longitude	
				Start	End
Item	DRAFT DWR UCIP LMA Responsibility			37.965880 °	37.965880 °
				-121.135897 °	-121.135897 °
DWR ID	23344				
Comment Code					
Inspector Comment					
DS_ID:23344					
FS_ID:36144					
EP_NO: N/A					
Repair Type: Non-Urgent					
Crossing Status: Found					
UCIP Comments: Inlet appears to be burried with soil on LS. Pipe heavily corroded at outlet on WS toe. Good candidate for video inspection.					
FIELD_STRUCT_DESC: 18-inch corrugated metal drainage pipe, 3.5 feet below the roadway. Grouted spillway and inlet. [Additional Reference(s): DWR Levee Log, 1992. USACE San Joaquin O&M Manual 611.1, Volume F, (HLM 9.77)].					
FS Date: 4/30/2014

Inlet on LS shoulder burried in soil.

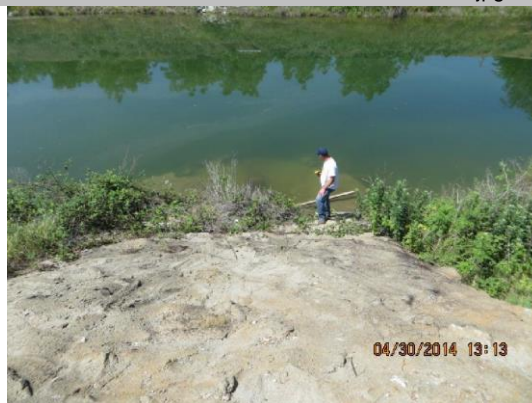
Photo 2 of 3 : UCIP_FA_2019_36144_65405.jpg

Grout over pipe on WS slope with pipe visible in water at WS toe.

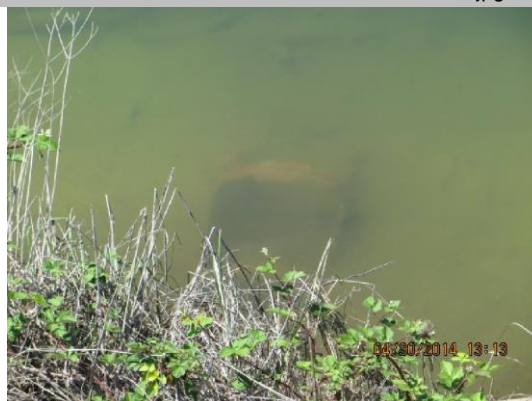
Photo 3 of 3 : UCIP_FA_2019_36144_65404.jpg

Pipe completely rusted through at outlet on WS toe.

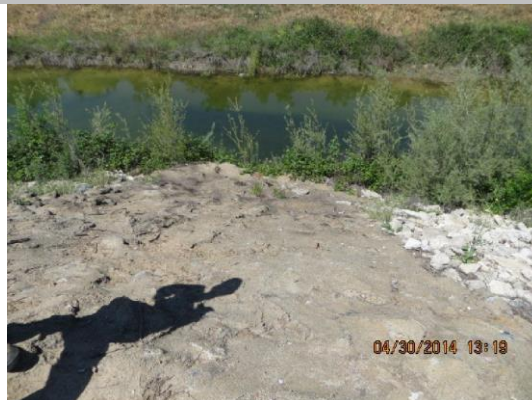
Photo 1 of 3 : UCIP_FA_2019_36145_65409.jpg

LM Start	9.78	Rating **	M	Issue No.	830
LM End	9.78	Issue Type +	Ma	Location *	
Category	Supplemental			GPS Latitude/Longitude	
				Start	End
Item	DRAFT DWR UCIP LMA Responsibility			37.964912 °	37.964912 °
				-121.140827 °	-121.140827 °
DWR ID	23345				
Comment Code					
Inspector Comment					
DS_ID:23345 FS_ID:36145 EP_NO: N/A Repair Type: Non-Urgent Crossing Status: Found UCIP Comments: Inlet on LS buried in soil. FIELD_STRUCT_DESC: 18-inch corrugated metal drainage pipe through the levee, 3.5 feet below the crown. Grouted spillway and inlet. [Additional Reference(s): DWR Levee Log, 1992. USACE San Joaquin O&M Manual 611.1, Volume F, (HLM 10.07)]. FS Date: 4/30/2014

Grout over pipe on WS slope.

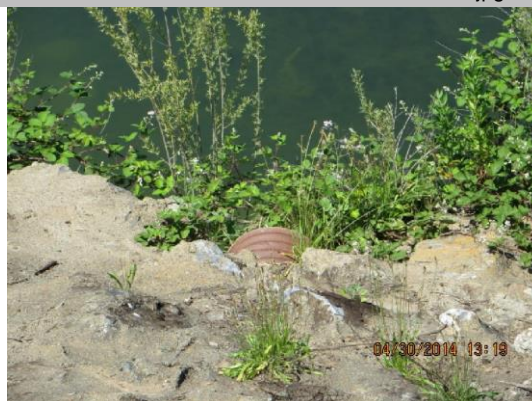
Photo 2 of 3 : UCIP_FA_2019_36145_65408.jpg

Pipe at outlet on WS toe.

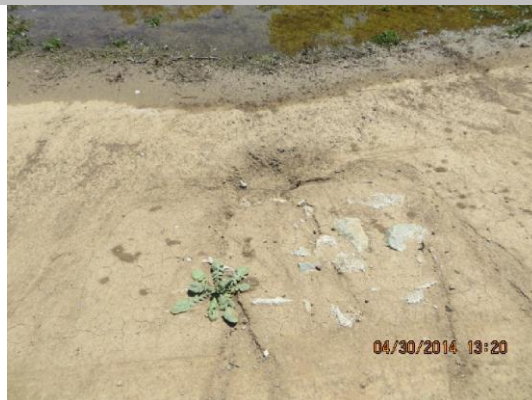
Photo 3 of 3 : UCIP_FA_2019_36145_65407.jpg

Inlet appears to be buried in soil on LS shoulder.

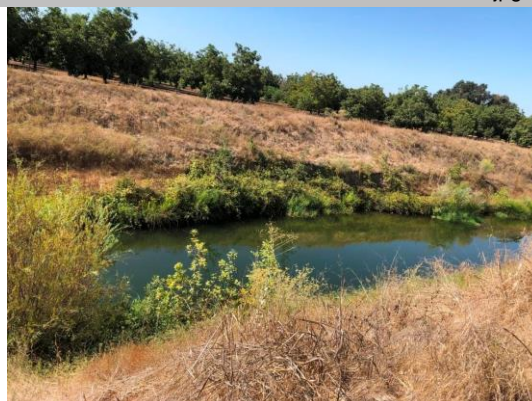
Photo 1 of 3 : SJR2019_NA0017U16RM12.95_1.jpg

Site ID: NA0017U16RM12.95
 08/29/2019: No significant change observed. This area is patrol road only.
 08/30/2017: No significant change observed.
 08/16/2016: No significant change observed.
 08/12/2015: No significant change observed.
 08/20/2014: No significant change observed.
 09/12/2013: No significant change observed.
 08/22/2012: Dense vegetation on site. There is no levee structure on site. The levee crest width and levee height were not measured or estimated in the field.

Upstream view of the site from right river bank.

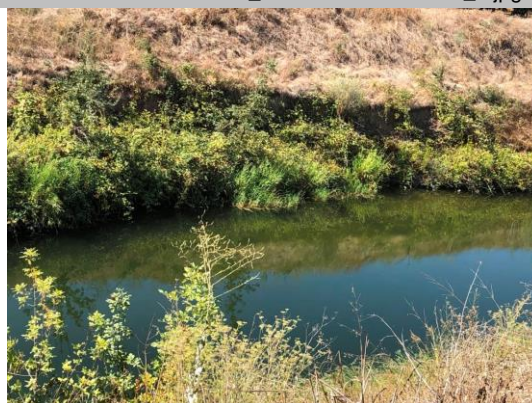
Photo 2 of 3 : SJR2019_NA0017U16RM12.95_2.jpg

Close-up view of the erosion.

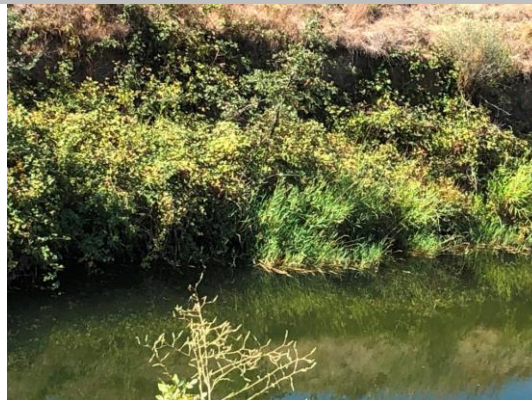
Photo 3 of 3 : SJR2019_NA0017U16RM12.95_3.jpg

Close-up view of the erosion.

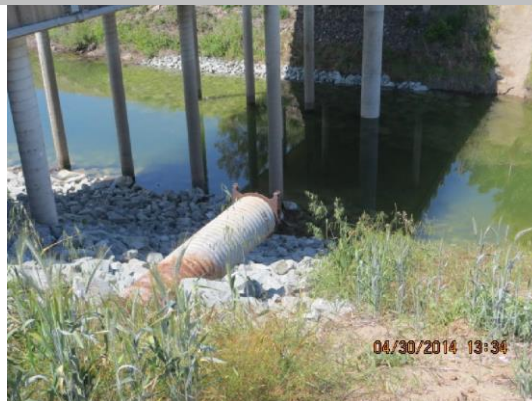
Photo 1 of 3 : UCIP_FA_2019_36163_65442.jpg

LM Start	10.20	Rating **	M	Issue No.	832	
LM End	10.20	Issue Type +	Ma	Location *		
Category	Supplemental			GPS Latitude/Longitude		
				Start	End	
Item	DRAFT DWR UCIP LMA Responsibility			37.964670 °	37.964670 °	
				-121.148455 °	-121.148455 °	
DWR ID	23347					
Comment Code						
Inspector Comment						
DS_ID:23347						
FS_ID:36163						
EP_NO: N/A						
Repair Type: Non-Urgent						
Crossing Status: Found						
UCIP Comments: Heavy sediment buildup at inlet on LS toe.						
FIELD_STRUCT_DESC: 18-inch corrugated metal drainage pipe through the levee, 5.5 feet below the crown. Concrete U-shaped headwall on the landside (LS). Flap gate on the waterside (WS) end.						
[Additional Reference(s): DWR Levee Log, 1992. USACE San Joaquin O&M Manual 611.1, Volume F, (HLM 10.50)].						
FS Date: 4/30/2014

Pipe and flapgate visible on WS slope.

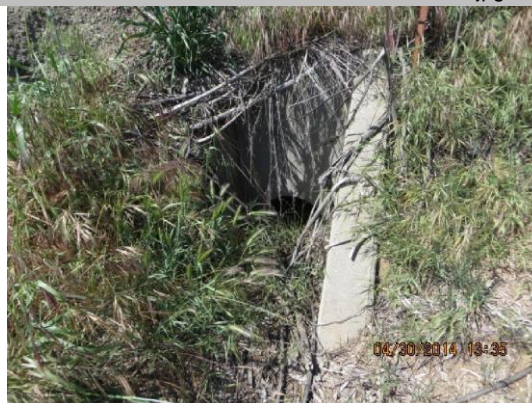
Photo 3 of 3 : UCIP_FA_2019_36163_65440.jpg

DS_ID:23347
FS_ID:36163
EP_NO: N/A
Repair Type: Non-Urgent
Crossing Status: Found
UCIP Comments: Heavy sediment buildup at inlet on LS toe.
FIELD_STRUCT_DESC: 18-inch corrugated metal drainage pipe through the levee, 5.5 feet below the crown. Concrete U-shaped headwall on the landside (LS). Flap gate on the waterside (WS) end.
[Additional Reference(s): DWR Levee Log, 1992. USACE San Joaquin O&M Manual 611.1, Volume F, (HLM 10.50)].
FS Date: 4/30/2014

Headwall and pipe with heavy sediment buildup on LS toe.

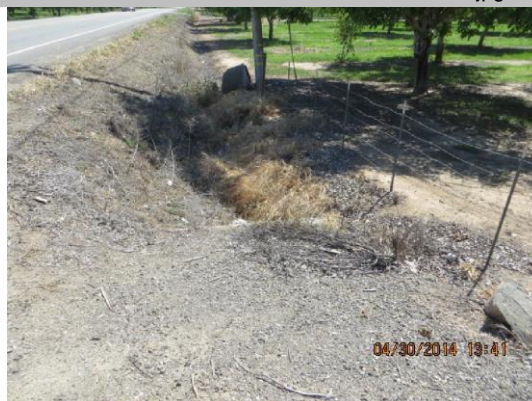
Photo 1 of 3 : UCIP_FA_2019_36164_65445.jpg

LM Start	10.21	Rating **	A/W	Issue No.	834
LM End	10.21	Issue Type +	Ma	Location *	
Category	Supplemental			GPS Latitude/Longitude	
				Start	End
Item	DRAFT DWR UCIP LMA Responsibility			37.964660 °	37.964660 °
				-121.148660 °	-121.148660 °
DWR ID	23348				
Comment Code					
Inspector Comment					
DS_ID:23348					
FS_ID:36164					
EP_NO: N/A					
Repair Type: No Action Needed					
Crossing Status: Found					
UCIP Comments:					
FIELD_STRUCT_DESC: 18-inch corrugated metal drainage pipe through the levee, 6 feet below the crown. Concrete headwall on the landside (LS). Flap gate on the waterside (WS). [Additional Reference(s): DWR Levee Log, 1992. USACE San Joaquin O&M Manual 611.1, Volume F, (HLM 10.51)].					
FS Date: 4/30/2014

Pipe and concrete headwall on LS toe.

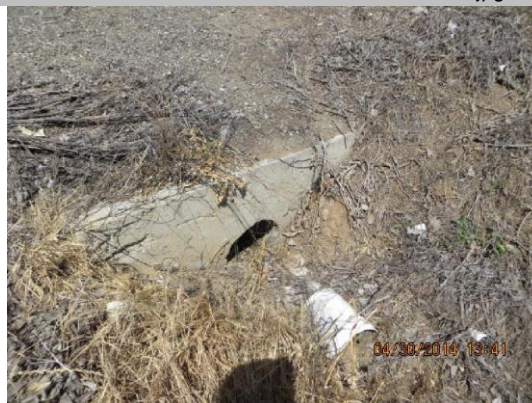
Photo 2 of 3 : UCIP_FA_2019_36164_65444.jpg

Pipe and concrete headwall on LS toe. Sediment buildup on LS toe.

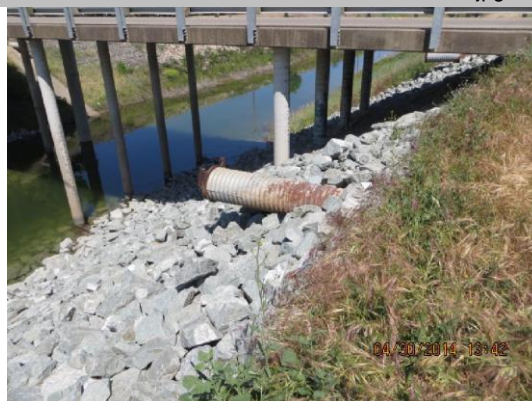
Photo 3 of 3 : UCIP_FA_2019_36164_65443.jpg

Pipe and flapgate visible on WS slope.

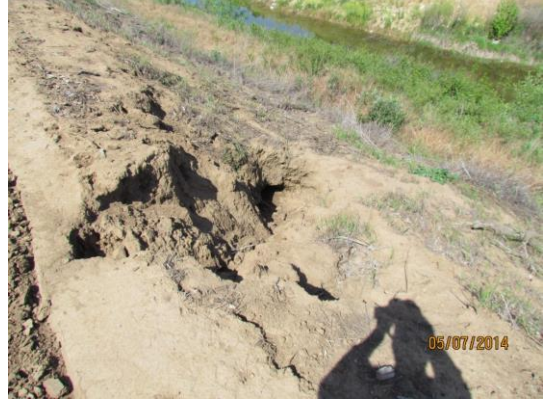
Photo 1 of 2 : FA_2019_NA0017_160_139_20190830_00152.jpg

LM Start	10.79	Rating **	A/W	Issue No.	139
LM End	10.79	Issue Type +	Ma	Location *	WS
Category	Earthen Levee			GPS Latitude/Longitude	
				Start	End
Item	Erosion / Bank Caving			37.962182°	37.962182°
				-121.158684°	-121.158684°
DWR ID	DWR_NA0017_16_s_2013_139				
Comment Code					
E1 : Note and monitor erosion site.					
Inspector Comment

Picture of the erosion on the waterside shoulder of the levee looking downstream.

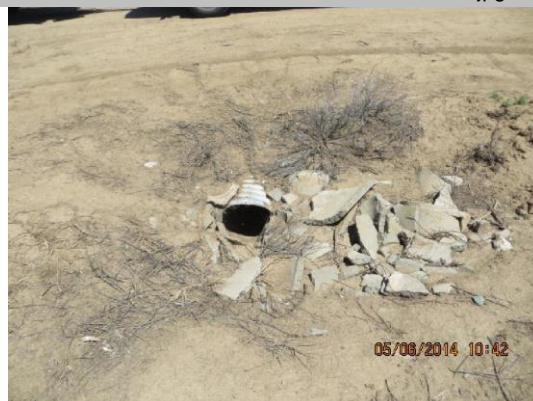
Photo 1 of 2 : UCIP_FA_2019_36186_65505.jpg

LM Start	11.08	Rating **	A/W	Issue No.	841	
LM End	11.08	Issue Type +	Ma	Location *		
Category	Supplemental			GPS Latitude/Longitude		
				Start	End	
Item	DRAFT DWR UCIP LMA Responsibility			37.960565°	37.960565°	
				-121.163287°	-121.163287°	
DWR ID	23354					
Comment Code						
Inspector Comment						
DS_ID:23354						
FS_ID:36186						
EP_NO: N/A						
Repair Type: No Action Needed						
Crossing Status: Found						
UCIP Comments:						
FIELD_STRUCT_DESC: 18-inch corrugated metal drainage pipe through the levee, 3.5 feet below the roadway. Grouted spillway.						
[Additional Reference(s): DWR Levee Log, 1992. USACE San Joaquin O&M Manual 611.1, Volume F, (HLM 11.41)].						
FS Date: 5/6/2014

Pipe at inlet on LS toe.

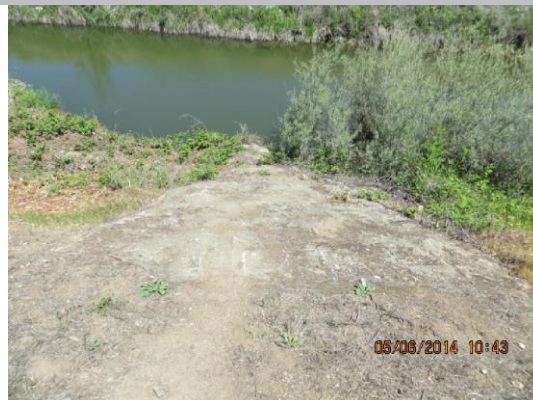
Photo 2 of 2 : UCIP_FA_2019_36186_65504.jpg

Grout over pipe on WS slope.

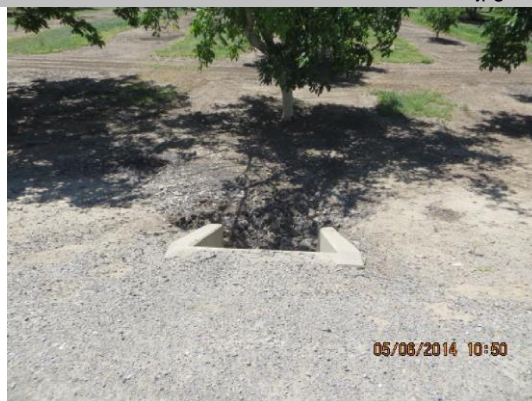
Photo 1 of 3 : UCIP_FA_2019_36187_65508.jpg

LM Start	11.15	Rating **	A/W	Issue No.	842
LM End	11.15	Issue Type +	Ma	Location *	
Category	Supplemental			GPS Latitude/Longitude	
				Start	End
Item	DRAFT DWR UCIP LMA Responsibility			37.960322 °	37.960322 °
				-121.164400 °	-121.164400 °
DWR ID	23355				
Comment Code					
Inspector Comment					
DS_ID:23355					
FS_ID:36187					
EP_NO: N/A					
Repair Type: No Action Needed					
Crossing Status: Found					
UCIP Comments:					
FIELD_STRUCT_DESC: 30-inch steel drainage pipe through the levee, 6 feet below the crown. Concrete U-shaped headwall on both ends. Flap gate on the waterside (WS) end. Grouted inlet and outlet. [Additional Reference(s): DWR Levee Log, 1992. USACE San Joaquin O&M Manual 611.1, Volume F, (HLM 11.45) corrugated metal pipe listed].					
FS Date: 5/6/2014

Pipe and headwall visible on LS toe.

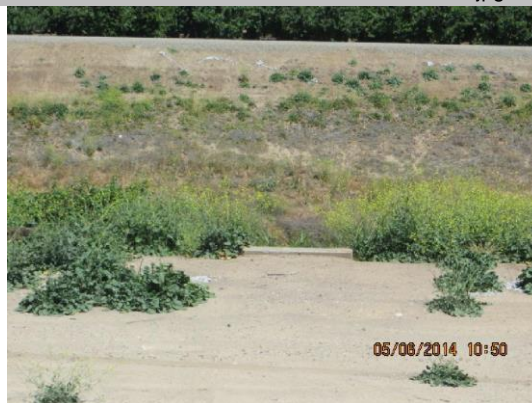
Photo 2 of 3 : UCIP_FA_2019_36187_65507.jpg

Pipe, flapgate, and headwall visible on WS shoulder.

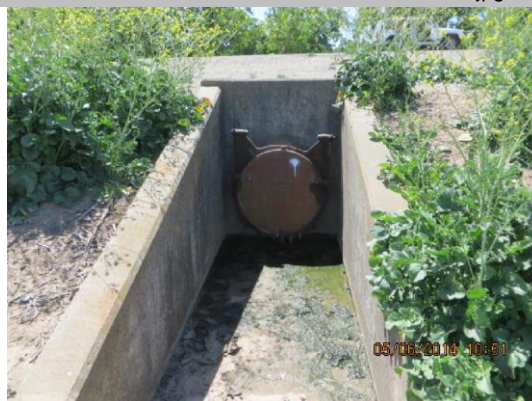
Photo 3 of 3 : UCIP_FA_2019_36187_65506.jpg

Pipe, flapgate, and headwall visible on WS shoulder.

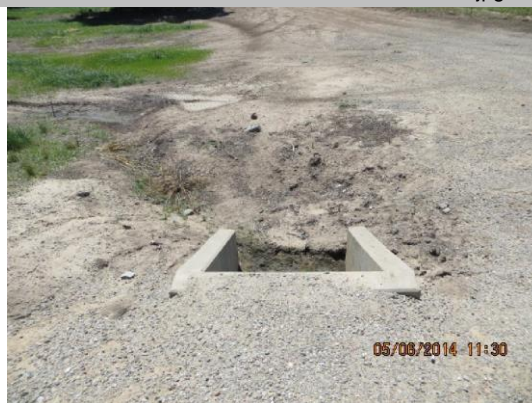
Photo 1 of 3 : UCIP_FA_2019_36208_65571.jpg

LM Start	11.92	Rating **	A/W	Issue No.	845
LM End	11.92	Issue Type +	Ma	Location *	
Category	Supplemental			GPS Latitude/Longitude	
				Start	End
Item	DRAFT DWR UCIP LMA Responsibility			37.961429 °	37.961429 °
				-121.178380 °	-121.178380 °
DWR ID	23385				
Comment Code					
Inspector Comment					
DS_ID:23385					
FS_ID:36208					
EP_NO: N/A					
Repair Type: No Action Needed					
Crossing Status: Found					
UCIP Comments:					
FIELD_STRUCT_DESC: 30-inch corrugated metal drainage pipe through the levee, 5.5 feet below the crown. Concrete U-shaped headwall on both ends. Grouted inlet and outlet. Flap gate on the waterside (WS) end. [Additional Reference(s): DWR Levee Log, 1992. USACE San Joaquin O&M Manual 611.1, Volume F, (HLM 12.24)].					
FS Date: 5/6/2014

Concrete headwall on LS toe.

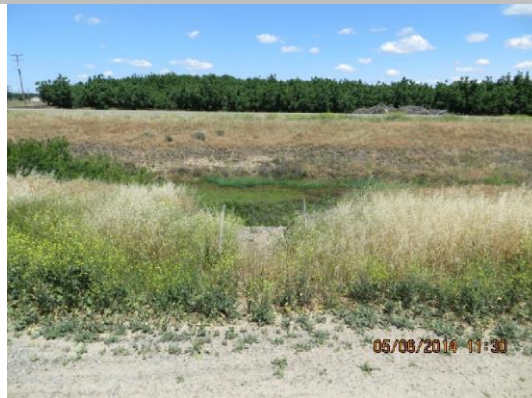
Photo 2 of 3 : UCIP_FA_2019_36208_65570.jpg

Pipe and concrete headwall on WS slope.

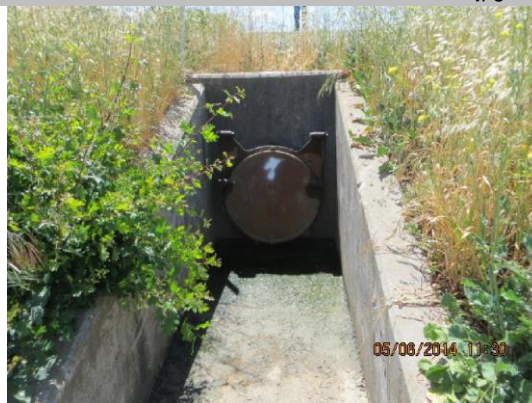
Photo 3 of 3 : UCIP_FA_2019_36208_65569.jpg

Pipe, headwall, and flapgate on WS slope.

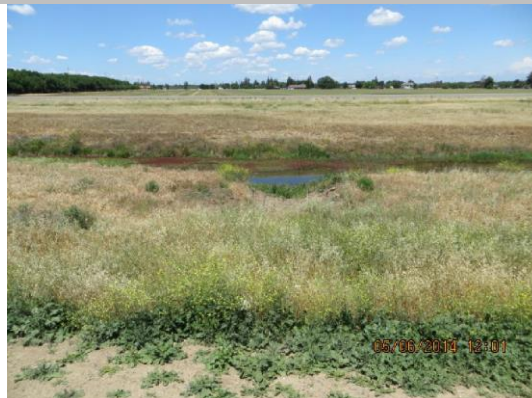
Photo 1 of 3 : UCIP_FA_2019_36225_65589.jpg

LM Start	12.26	Rating **	A/W	Issue No.	847	
LM End	12.26	Issue Type +	Ma	Location *		
Category	Supplemental			GPS Latitude/Longitude		
				Start	End	
Item	DRAFT DWR UCIP LMA Responsibility			37.960568 °	37.960568 °	
				-121.184451 °	-121.184451 °	
DWR ID	23388					
Comment Code						
Inspector Comment						
DS_ID:23388						
FS_ID:36225						
EP_NO: N/A						
Repair Type: No Action Needed						
Crossing Status: Found						
UCIP Comments:						
FIELD_STRUCT_DESC: 30-inch corrugated metal drainage pipe through the levee, 9 feet below the crown. Concrete U-shaped headwall on both ends. Grouted inlet and outlet. Flap gate on the waterside (WS) end. [Additional Reference(s): DWR Levee Log, 1992. USACE San Joaquin O&M Manual 611.1, Volume F, (HLM 12.58)].						
FS Date: 5/6/2014

Grouted spilway on WS berm.

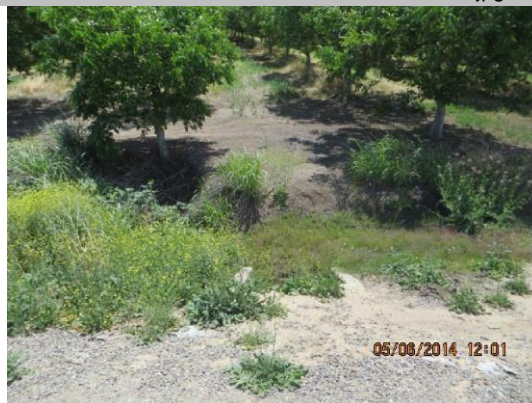
Photo 2 of 3 : UCIP_FA_2019_36225_65588.jpg

Concrete headwall on LS toe.

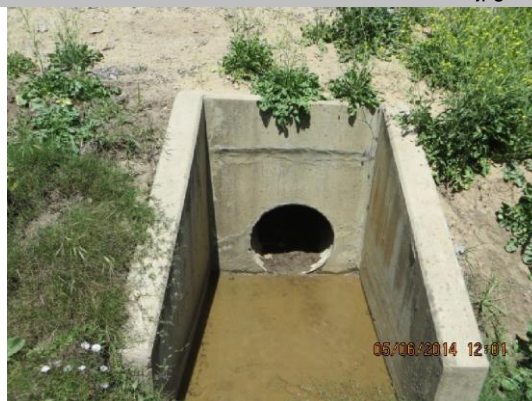
Photo 3 of 3 : UCIP_FA_2019_36225_65587.jpg

LM Start	12.26	Rating **	A/W	Issue No.	847 (cont)	
LM End	12.26	Issue Type +	Ma	Location *		
Category	Supplemental			GPS Latitude/Longitude		
				Start	End	
Item	DRAFT DWR UCIP LMA Responsibility			37.960568 °	37.960568 °	
				-121.184451 °	-121.184451 °	
DWR ID	23388					
Comment Code						
Inspector Comment						
DS_ID:23388						
FS_ID:36225						
EP_NO: N/A						
Repair Type: No Action Needed						
Crossing Status: Found						
UCIP Comments:						
FIELD_STRUCT_DESC: 30-inch corrugated metal drainage pipe through the levee, 9 feet below the crown. Concrete U-shaped headwall on both ends. Grouted inlet and outlet. Flap gate on the waterside (WS) end. [Additional Reference(s): DWR Levee Log, 1992. USACE San Joaquin O&M Manual 611.1, Volume F, (HLM 12.58)].						
FS Date: 5/6/2014

Concrete headwall on LS toe.

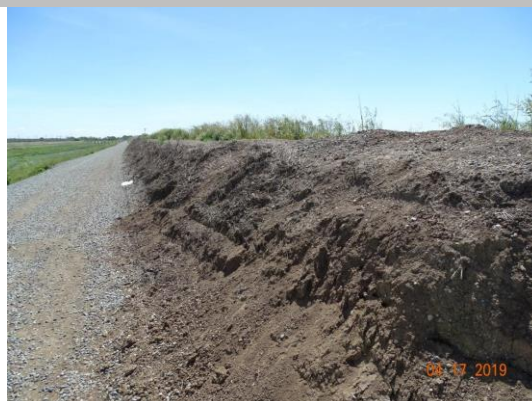
Photo 1 of 1 : FA_2019_NA0017_160_277_20190830_00200.jpg

LM Start	13.56	Rating **	U	Issue No.	277
LM End	14.01	Issue Type +	Ma	Location *	CR
Category	Earthen Levee			GPS Latitude/Longitude	
				Start	End
Item	Encroachments			37.961604 °	37.965214 °
				-121.206605 °	-121.213627 °
DWR ID	DWR_NA0017_16_s_2019_277				
Comment Code					
MA : Material					
Inspector Comment					
Fill material stored on landside crown.

View of fill material stored landside shoulder. (Spring 2019)

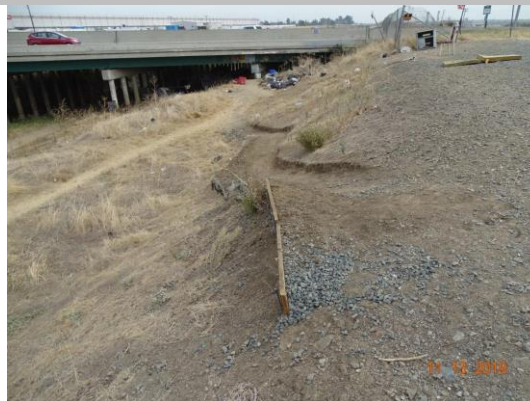
Photo 1 of 2 : FA_2019_NA0017_160_316_20191118_00457.jpg

LM Start	16.32	Rating **	U	Issue No.	316
LM End	16.33	Issue Type +	Ma	Location *	WS
Category	Earthen Levee			GPS Latitude/Longitude	
				Start	End
Item	Slope Stability			37.981633 °	37.981711 °
				-121.250452 °	-121.250620 °
DWR ID	DWR_NA0017_16_f_2019_316				
Comment Code					
S2 : Repair the levee slope damaged by foot traffic and prevent access where possible.					
Inspector Comment					
Foot path cutting into waterside slope.

View of foot path cutting into waterside slope. Fall 2019

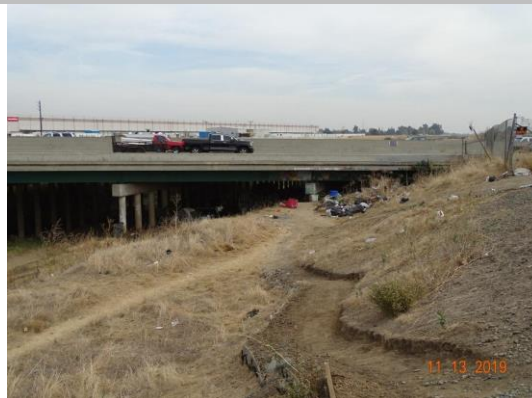
Photo 2 of 2 : FA_2019_NA0017_160_316_20191118_00458.jpg

LM Start	16.32	Rating **	U	Issue No.	316 (cont)
LM End	16.33	Issue Type +	Ma	Location *	WS
Category	Earthen Levee			GPS Latitude/Longitude	
				Start	End
Item	Slope Stability			37.981633 °	37.981711 °
				-121.250452 °	-121.250620 °
DWR ID	DWR_NA0017_16_f_2019_316				
Comment Code					
S2 : Repair the levee slope damaged by foot traffic and prevent access where possible.					
Inspector Comment					
Foot path cutting into waterside slope.

View of foot path cutting into waterside slope. Fall 2019

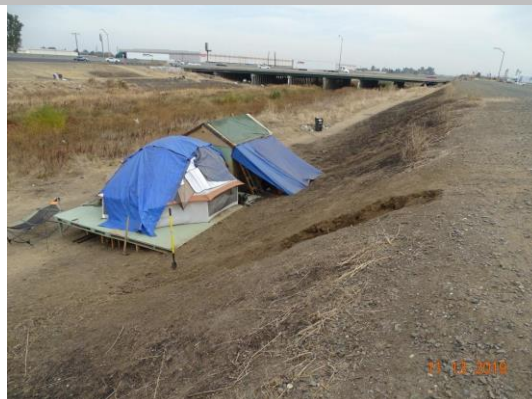
Photo 1 of 2 : FA_2019_NA0017_160_317_20191118_00460.jpg

LM Start	16.40	Rating **	M	Issue No.	317
LM End	16.40	Issue Type +	Ma	Location *	LS
Category	Earthen Levee			GPS Latitude/Longitude	
				Start	End
Item	Slope Stability			37.982188 °	37.982188 °
				-121.251709 °	-121.251709 °
DWR ID	DWR_NA0017_16_f_2019_317				
Comment Code					
S2 : Repair the levee slope damaged by foot traffic and prevent access where possible.					
Inspector Comment					
There are excavated steps cut into waterside slope. RD is working to repair levee slope.

View of step excavation into waterside slope. Fall 2019

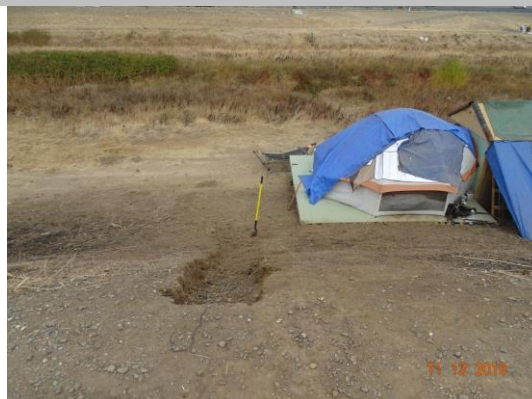
Photo 2 of 2 : FA_2019_NA0017_160_317_20191118_00461.jpg

View of step excavation into waterside slope. Fall 2019

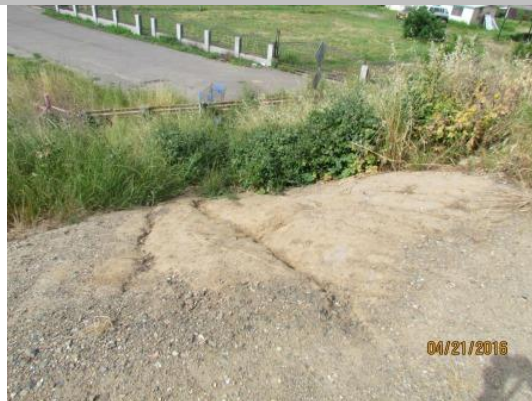
Photo 1 of 1 : FA_2019_NA0017_160_293_20190830_00204.jpg

LM Start	17.14	Rating **	M	Issue No.	293	
LM End	17.14	Issue Type +	Ma	Location *	LS	
Category	Earthen Levee			GPS Latitude/Longitude		
				Start		End
Item	Slope Stability			37.987210 °		37.987210 °
				-121.263501 °		-121.263501 °
DWR ID	DWR_NA0017_16_s_2016_293					
Comment Code						
S2 : Repair the levee slope damaged by foot traffic and prevent access where possible.						
Inspector Comment						
Landside slope erosion caused by foot traffic.

View of an erosion on the landside slope of the levee.

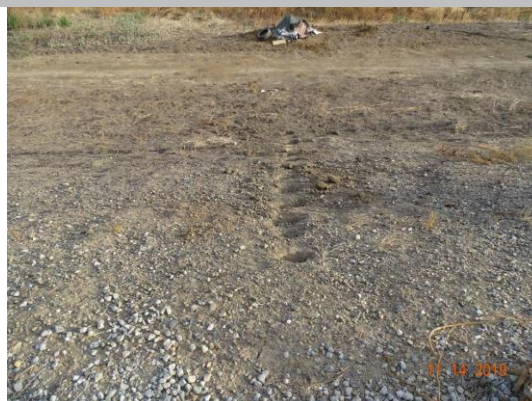
Photo 1 of 1 : FA_2019_NA0017_160_325_20191118_00471.jpg

LM Start	17.69	Rating **	M	Issue No.	325
LM End	17.69	Issue Type +	Ma	Location *	LS
Category	Earthen Levee			GPS Latitude/Longitude	
				Start	End
Item	Slope Stability			37.990961 °	37.990961 °
				-121.272371 °	-121.272371 °
DWR ID	DWR_NA0017_16_f_2019_325				
Comment Code					
S2 : Repair the levee slope damaged by foot traffic and prevent access where possible.					
Inspector Comment					
Foot path on waterside slope.

View of foot path on waterside slope. Fall 2019

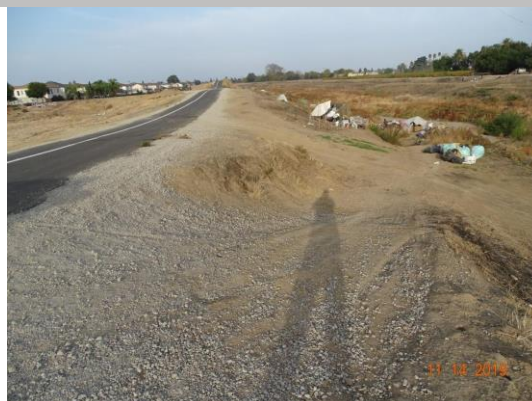
Photo 1 of 1 : FA_2019_NA0017_160_327_20191118_00474.jpg

LM Start	17.83	Rating **	M	Issue No.	327
LM End	17.83	Issue Type +	Ma	Location *	WS
Category	Earthen Levee			GPS Latitude/Longitude	
				Start	End
Item	Slope Stability			37.991949 °	37.991949 °
				-121.274683 °	-121.274683 °
DWR ID	DWR_NA0017_16_f_2019_327				
Comment Code					
S2 : Repair the levee slope damaged by foot traffic and prevent access where possible.					
Inspector Comment					
Foot path on waterside slope.

View of foot path on waterside slope. Fall 2019

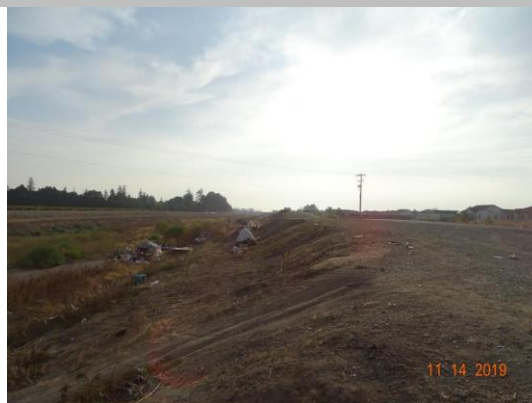
Photo 1 of 2 : FA_2019_NA0017_160_328_20191118_00476.jpg

LM Start	17.87	Rating **	M	Issue No.	328
LM End	17.95	Issue Type +	Ma	Location *	WS
Category	Earthen Levee			GPS Latitude/Longitude	
				Start	End
Item	Slope Stability			37.992220 °	37.992768 °
				-121.275317 °	-121.276659 °
DWR ID	DWR_NA0017_16_f_2019_328				
Comment Code					
S2 : Repair the levee slope damaged by foot traffic and prevent access where possible.					
Inspector Comment					
Foot path cutting into waterside slope.

View of foot path cutting into waterside slope. Fall 2019

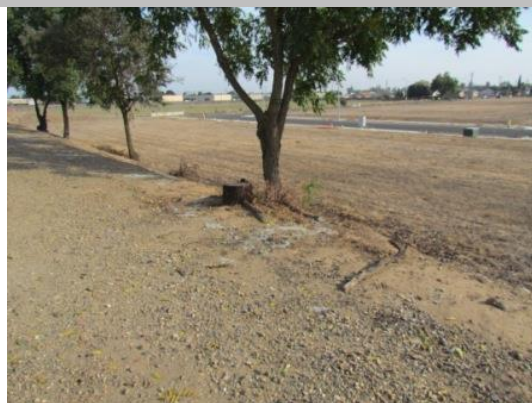
Photo 1 of 1 : FA_2019_NA0017_160_65_20190830_00088.jpg

LM Start	18.94	Rating **	N	Issue No.	65
LM End	18.94	Issue Type +	Ma	Location *	LS
Category	Earthen Levee			GPS Latitude/Longitude	
				Start	End
Item	Trim / Thin Trees			37.991937°	37.991937°
				-121.293932°	-121.293932°
DWR ID	DWR_NA0017_16_s_2012_65				
Comment Code					
T5 : Tree stumps.					
Inspector Comment

A tree stump was found on the landside of the levee looking upstream.

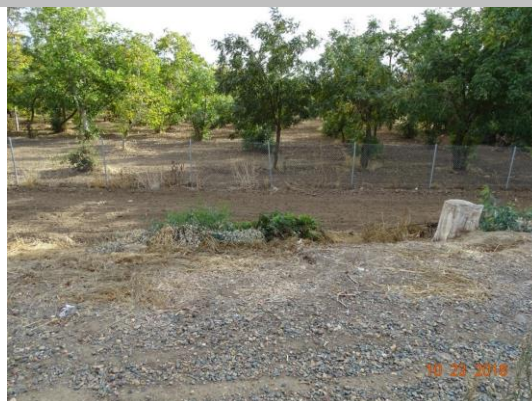
Photo 1 of 1 : FA_2019_NA0017_160_310_20190830_00211.jpg

LM Start	19.15	Rating **	N	Issue No.	310
LM End	19.15	Issue Type +	Ma	Location *	LS
Category	Earthen Levee			GPS Latitude/Longitude	
				Start	End
Item	Trim / Thin Trees			37.991113°	37.991113°
				-121.297598°	-121.297598°
DWR ID	DWR_NA0017_16_f_2018_310				
Comment Code					
T5 : Tree stumps.					
Inspector Comment

View of tree stumps on the landside slope (October 2018).

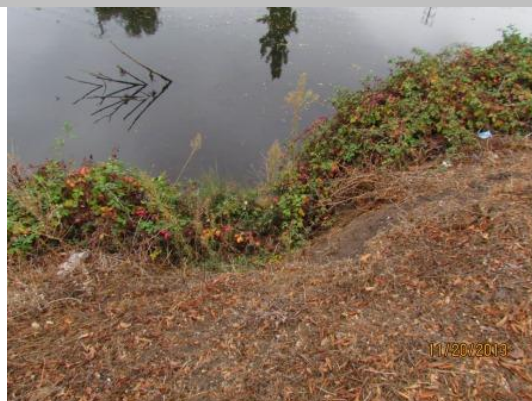
Photo 1 of 1 : FA_2019_NA0017_160_62_20190830_00083.jpg

LM Start	21.94	Rating **	M	Issue No.	62
LM End	21.94	Issue Type +	Ma	Location *	WS
Category	Earthen Levee			GPS Latitude/Longitude	
				Start	End
Item	Erosion / Bank Caving			37.979251°	37.979251°
				-121.340012°	-121.340012°
DWR ID	DWR_NA0017_16_f_2013_62				
Comment Code					
E2 : Schedule repair of erosion site prior to the next inspection.					
Inspector Comment

Erosion was found on the waterside slope of the levee looking upstream.

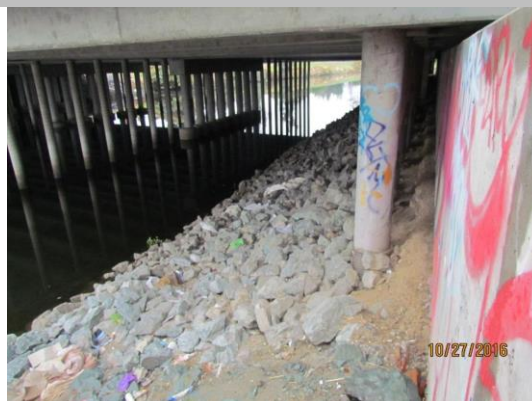
Photo 1 of 5 : FA_2019_NA0017_160_48_20190830_00063.jpg

LM Start	22.04	Rating **	A/W	Issue No.	48
LM End	22.04	Issue Type +	Ma	Location *	WS
Category	Earthen Levee			GPS Latitude/Longitude	
				Start	End
Item	Erosion / Bank Caving			37.978697 °	37.978697 °
				-121.341581 °	-121.341581 °
DWR ID	DWR_NA0017_16_s_2012_48				
Comment Code					
E2 : Schedule repair of erosion site prior to the next inspection.					
Inspector Comment					
Caltrans repaired the issue. (Permit # 18562) Another repair might be needed if it deteriorates.

View of the riprap on the waterside slope of the levee. Fall 2016

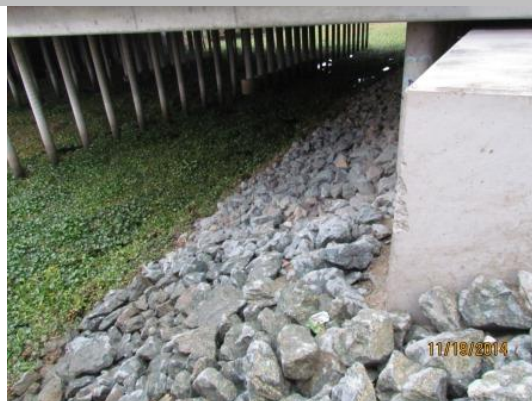
Photo 2 of 5 : FA_2019_NA0017_160_48_20190830_00064.jpg

Caltrans repaired the erosion under the southbound (I-5) bridge. The picture was taken from the crown looking upstream during fall 2014 inspection.

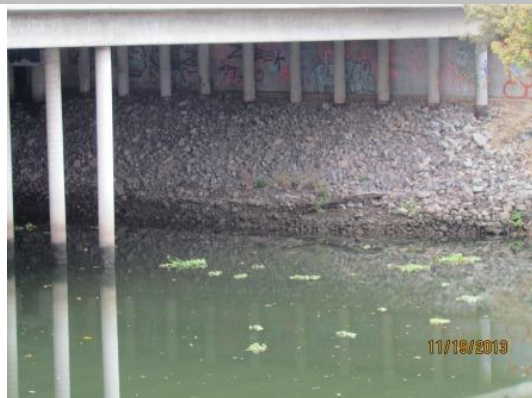
Photo 3 of 5 : FA_2019_NA0017_160_48_20190830_00065.jpg

Picture of erosion was found on the waterside toe of the levee looking from the opposite side of the levee. Fall 2013

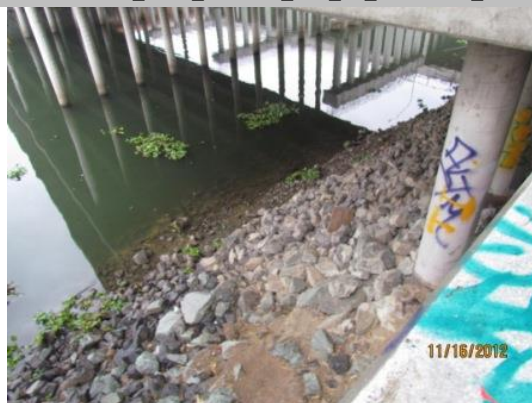
Photo 4 of 5 : FA_2019_NA0017_160_48_20190830_00066.jpg

View of the erosion site repaired by Caltrans on the waterside slope of the levee looking upstream. Fall 2012

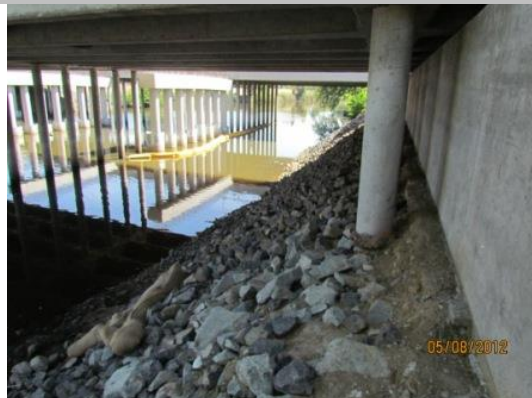
Photo 5 of 5 : FA_2019_NA0017_160_48_20190830_00067.jpg

LM Start	22.04	Rating **	A/W	Issue No.	48 (cont)	
LM End	22.04	Issue Type +	Ma	Location *	WS	
Category	Earthen Levee			GPS Latitude/Longitude		
				Start		End
Item	Erosion / Bank Caving			37.978697 °		37.978697 °
				-121.341581 °		-121.341581 °
DWR ID	DWR_NA0017_16_s_2012_48					
Comment Code						
E2 : Schedule repair of erosion site prior to the next inspection.						
Inspector Comment						
Caltrans repaired the issue. (Permit # 18562) Another repair might be needed if it deteriorates.

View of the erosion site repaired by Caltrans under the I-5 freeway going southbound. This picture was taken from the toe of the levee looking upstream. Spring 2012
