**Flood Control Project Maintenance
Levee Inspections**

Maintenance Issue Types Only, Levee Inspection Report By Mile - Fall 2019

San Joaquin County Flood Control and Water Conservation District

Waterway	Bank	Unit Miles	Inspection Start/End	Inspector
Unit No. 01 Littlejohn Creek	Left	2.59	11/14/2019 11/14/2019	Alberto De Leon

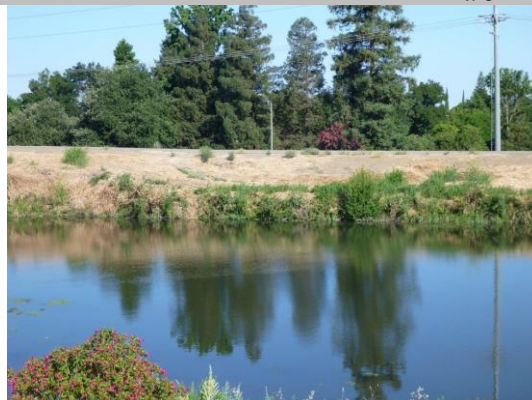
Photo 1 of 3 : LEVAL_FA_2019_474_2234.jpg

LM Start	22.19	Rating **	A/W	Issue No.	244
LM End	22.19	Issue Type +	Ma	Location *	
Category	Supplemental			GPS Latitude/Longitude	
				Start	End
Item	2017 Storm Damage			37.977185 °	37.977185 °
				-121.343687 °	-121.343687 °
DWR ID	LMA-301				
Comment Code					
Inspector Comment					
Levee Evaluation Comments					
Description:Erosion along the left bank of the waterside slope.					
Site ID No:474					
Site Designation:LMA-301					
Repair Type: Erosion					
Rating:Area of Concern					
Field Date:7/27/2017					
Notes: Lower priority because of the wide berm and erosion is only about 6 ft above water.

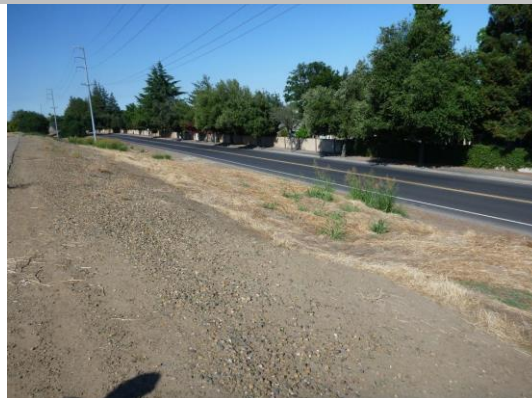
LM Start	22.19	Rating **	A/W	Issue No.	244 (cont)							
LM End	22.19	Issue Type +	Ma	Location *								
Category	Supplemental		GPS Latitude/Longitude									
			Start	End								
Item	2017 Storm Damage		37.977185°	37.977185°								
			-121.343687°	-121.343687°								
DWR ID	LMA-301											
Comment Code												
Inspector Comment												
Levee Evaluation Comments Description: Erosion along the left bank of the waterside slope. Site ID No: 474 Site Designation: LMA-301 Repair Type: Erosion Rating: Area of Concern Field Date: 7/27/2017 Notes: Lower priority because of the wide berm and erosion is only about 6 ft above water.

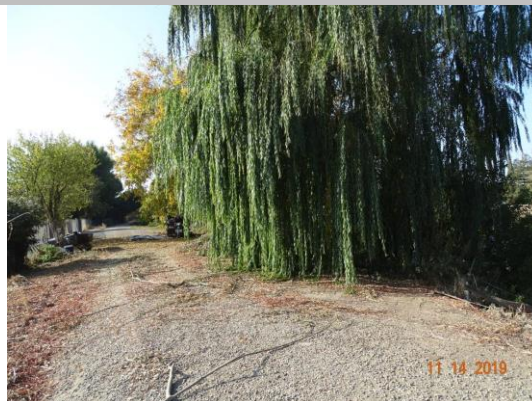
Photo 1 of 1 : FA_2019_NA0017_160_338_20191118_00483.jpg

LM Start	22.32	Rating **	U	Issue No.	338
LM End	22.32	Issue Type +	Ma	Location *	WS
Category	Earthen Levee			GPS Latitude/Longitude	
				Start	End
Item	Trim / Thin Trees			37.975819 °	37.975819 °
				-121.345294 °	-121.345294 °
DWR ID	DWR_NA0017_16_f_2019_338				
Comment Code					
T3 : Trim and thin trees to allow visibility of the ground and room to flood fight.					
Inspector Comment

View of tree that needs to be trimmed and thinned on waterside slope.
Fall 2019

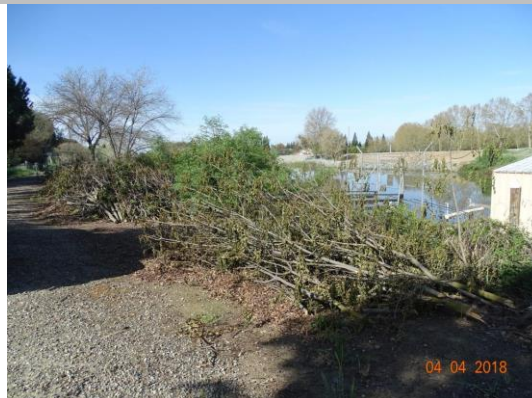
Photo 1 of 1 : FA_2019_NA0017_160_302_20190830_00208.jpg

LM Start	22.37	Rating **	M	Issue No.	302
LM End	22.37	Issue Type +	Ma	Location *	WS
Category	Earthen Levee			GPS Latitude/Longitude	
				Start	End
Item	Encroachments			37.975283 °	37.975283 °
				-121.345798 °	-121.345798 °
DWR ID	DWR_NA0017_16_s_2017_302				
Comment Code					
PR : Prunings					
Inspector Comment

Encroachment prunings on the crown looking east.

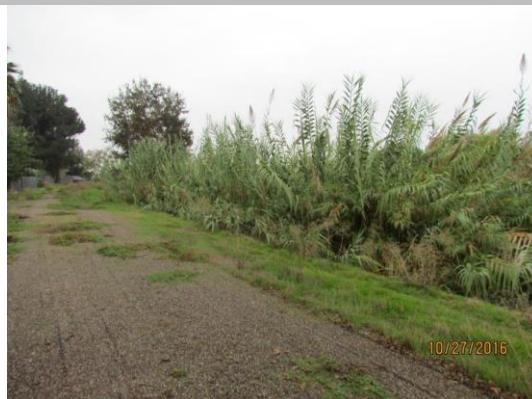
Photo 1 of 2 : FA_2019_NA0017_160_45_20190830_00056.jpg

LM Start	22.51	Rating **	U	Issue No.	45
LM End	22.57	Issue Type +	Ma	Location *	WS
Category	Earthen Levee			GPS Latitude/Longitude	
				Start	End
Item	Vegetation			37.973757 °	37.973299 °
				-121.347571 °	-121.348397 °
DWR ID	DWR_NA0017_16_f_2012_45				
Comment Code					
V2 : Remove the wild growth other than native grasses from the levee slopes.					
Inspector Comment					
Arundo on the waterside of the levee is completely blocking the visibility.

Picture of the arundo on the waterside slope of the levee. Fall 2016

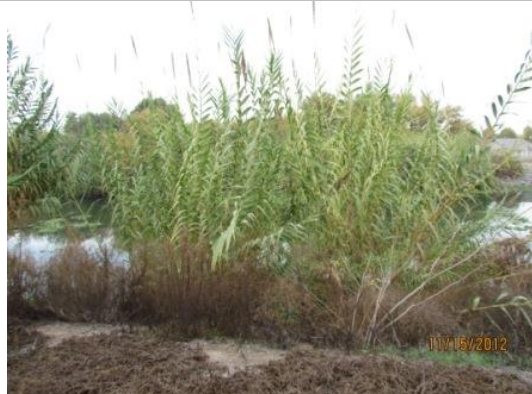
Photo 2 of 2 : FA_2019_NA0017_160_45_20190830_00057.jpg

Arundo was found on the waterside slope of the levee looking upstream.

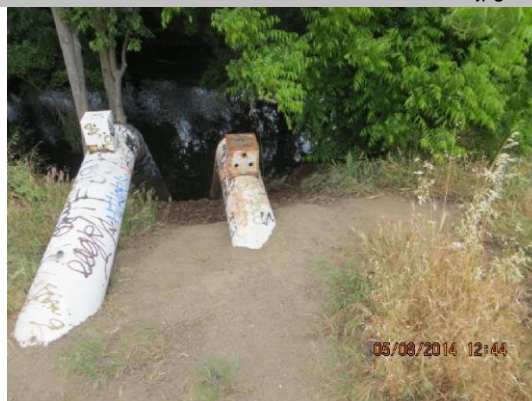
Photo 1 of 2 : UCIP_FA_2019_37423_67881.jpg

DS_ID:23409
FS_ID:37423
EP_NO: N/A
Repair Type: No Action Needed
Crossing Status: Found
UCIP Comments:
FIELD_STRUCT_DESC: 1 of 2: 18-inch steel drainage pipe through the levee, 4.3 feet below the crown. Siphon breaker on the waterside (WS) slope. Pump house near the landside (LS) toe. (Reclamation District No. 1618). [Additional Reference(s): DWR Levee Log, 1992. USACE San Joaquin O&M Manual 611.1, Volume F, (HLM 23.36)].
FS Date: 5/8/2014

Pipe visible on WS slope with siphon breaker in box.

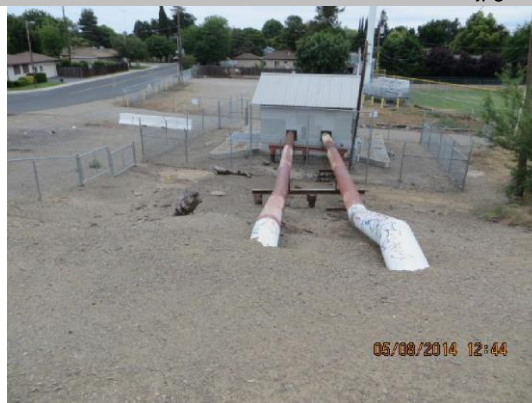
Photo 2 of 2 : UCIP_FA_2019_37423_67880.jpg

Pipe and pumphouse visible on LS toe.

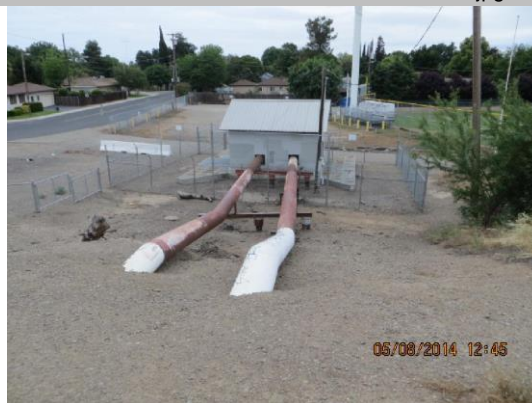
Photo 2 of 2 : UCIP_FA_2019_37424_67882.jpg

Pipe and pumphouse on LS toe.

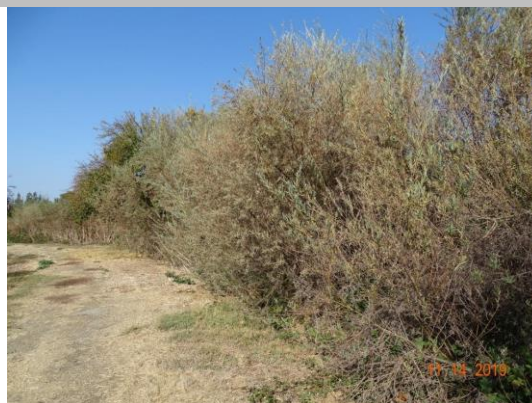
Photo 1 of 1 : FA_2019_NA0017_160_2_20191118_00484.jpg

LM Start	23.16	Rating **	U	Issue No.	2
LM End	23.47	Issue Type +	Ma	Location *	WS
Category	Earthen Levee			GPS Latitude/Longitude	
				Start	End
Item	Vegetation			37.968510 °	37.966144 °
				-121.355729 °	-121.360210 °
DWR ID	DWR_NA0017_16_s_2012_2				
Comment Code					
V2 : Remove the wild growth other than native grasses from the levee slopes.					
Inspector Comment

View of vegetation on waterside slope. Fall 2019

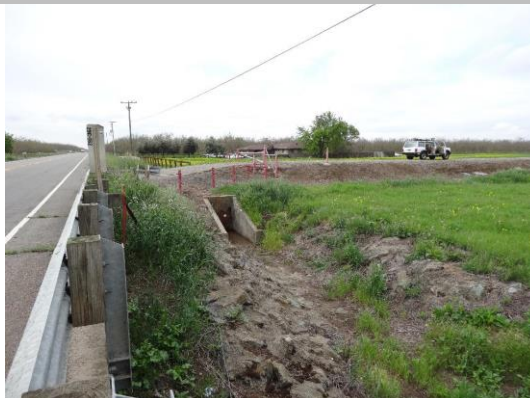
Photo 1 of 3 : UCIP_FA_2019_33112_59886.jpg

LM Start	0.00	Rating **	A/W	Issue No.	7	
LM End	0.00	Issue Type +	Ma	Location *		
Category	Supplemental			GPS Latitude/Longitude		
				Start	End	
Item	DRAFT DWR UCIP LMA Responsibility			37.957538 °	37.957538 °	
				-121.148502 °	-121.148502 °	
DWR ID	23952					
Comment Code						
Inspector Comment						
DS_ID:23952 FS_ID:33112 EP_NO: N/A Repair Type: No Action Needed Crossing Status: Found UCIP Comments: Looks well maintained crossing. FIELD_STRUCT_DESC: 30-inch CM pipe through the levee 6.0 feet below the crown. Concrete "U" headwalls on both ends. Flap gate on the waterward end. Grouted intake and outlet. O&M manual SJR 611.1 Vol. F- revised in 2010. FS Date: 4/4/2014

WS view: overview of pipe culvert and grouted riprap spillway.

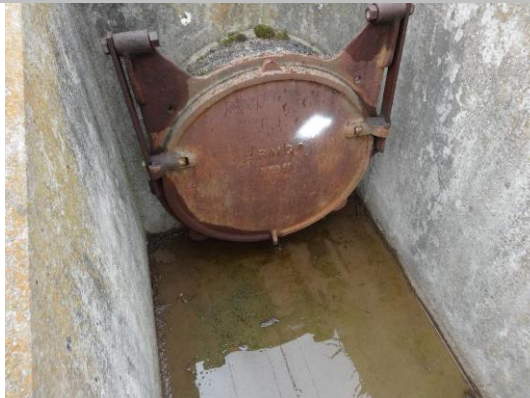
Photo 2 of 3 : UCIP_FA_2019_33112_59885.jpg

WS view: close view of CM pipe, flapgate, and concrete headwall.

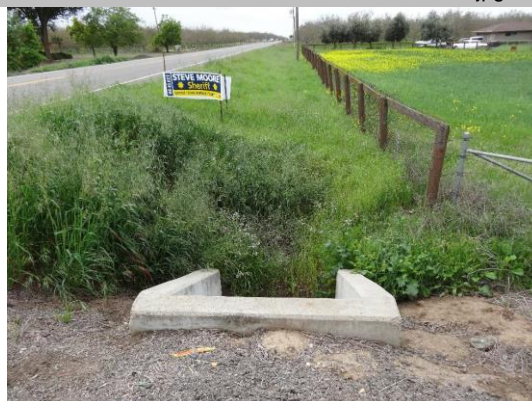
Photo 3 of 3 : UCIP_FA_2019_33112_59884.jpg

LS view: concrete headwall of pipe culvert.

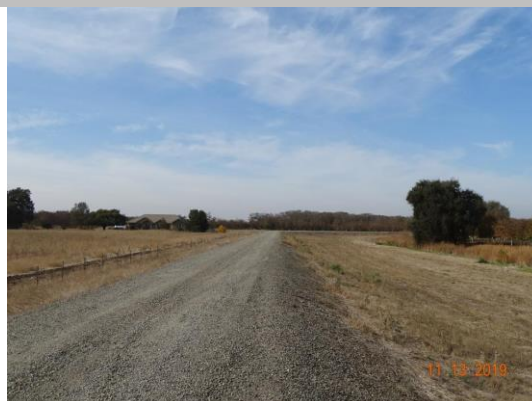
Photo 1 of 1 : FA_2019_NA0017_162_6_20191117_00013.jpg

LM Start	0.01	Rating **	A	Issue No.	6
LM End	0.01	Issue Type +	Ma	Location *	WS
Category	Earthen Levee			GPS Latitude/Longitude	
				Start	End
Item	Vegetation			37.957520 °	37.957520 °
				-121.148664 °	-121.148664 °
DWR ID	DWR_NA0017_18_f_2019_6				
Comment Code					
V1 : Control annual grass and weeds on the levee slopes and easements.					
Inspector Comment					
The annual vegetation in this section is well maintained, Fall 2019.

Typical view of vegetation on waterside slope. Fall 2019

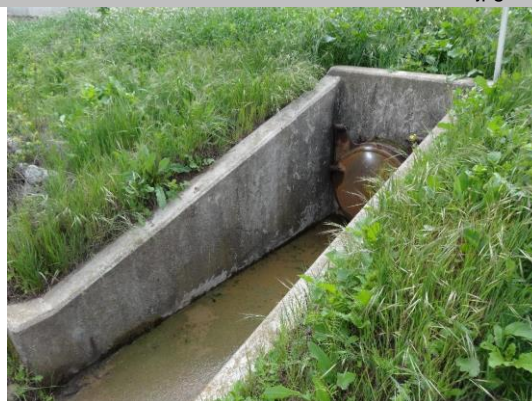
Photo 1 of 3 : UCIP_FA_2019_33113_59893.jpg

DS_ID:18541
FS_ID:33113
EP_NO: N/A
Repair Type: No Action Needed
Crossing Status: Found
UCIP Comments: Long flood wall along the levee.
FIELD_STRUCT_DESC: 30-inch corrugated metal drainage pipe through the levee, 6 feet below the crown. Concrete U-shaped headwall on both ends. Flap gate on the waterside (WS) end. Grouted inlet and outlet. [Additional Reference(s): DWR Levee Log, 1992, 36-inch pipe listed. USACE San Joaquin O&M Manual 611.1, Volume F, (HLM 0.28)].
FS Date: 4/4/2014

WS view: CM pipe, flapgate, and concrete headwall on levee slope.

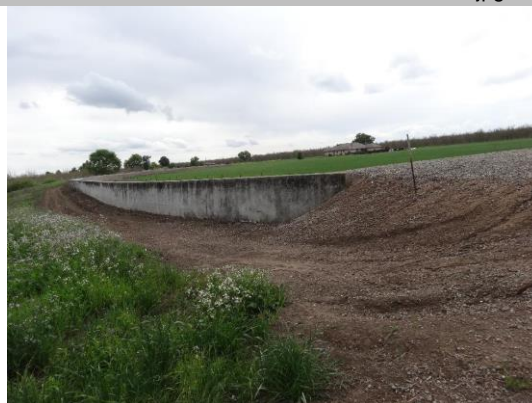
Photo 2 of 3 : UCIP_FA_2019_33113_59892.jpg

WS view: concrete flood wall along the levee on waterside.

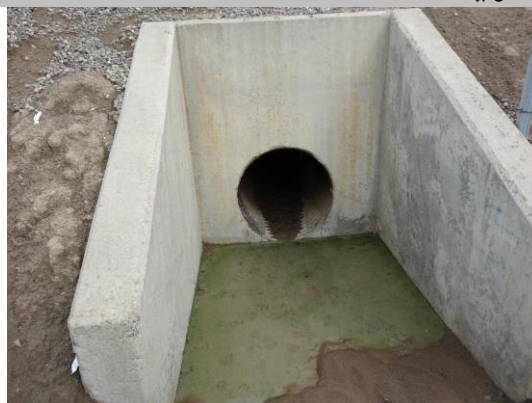
Photo 3 of 3 : UCIP_FA_2019_33113_59891.jpg

WS view: CM pipe, intake box, and concrete headwall on levee slope.

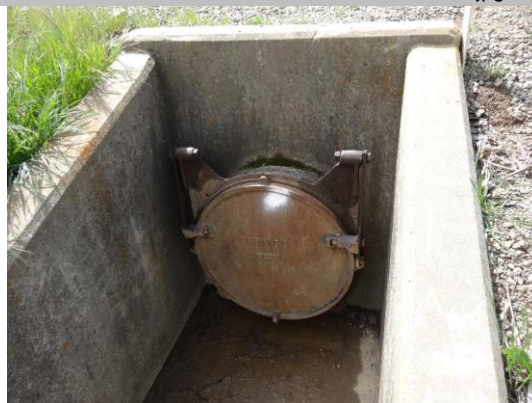
Photo 1 of 3 : UCIP_FA_2019_33114_59898.jpg

LM Start	0.53	Rating **	A/W	Issue No.	9	
LM End	0.53	Issue Type +	Ma	Location *		
Category	Supplemental			GPS Latitude/Longitude		
				Start		End
Item	DRAFT DWR UCIP LMA Responsibility			37.959117 °		37.959117 °
				-121.157567 °		-121.157567 °
DWR ID	18539					
Comment Code						
Inspector Comment						
DS_ID:18539 FS_ID:33114 EP_NO: N/A Repair Type: No Action Needed Crossing Status: Found UCIP Comments: May need cleaning the pipe. FIELD_STRUCT_DESC: 30-inch corrugated metal drainage pipe through the levee, 6 feet below the crown. Concrete U-shaped headwalls on both ends. Flap gate on the waterside (WS) end. Grouted inlet and outlet. [Additional Reference(s): DWR Levee Log, 1992, 36-inch pipe listed. USACE San Joaquin O&M Manual 611.1, Volume F, (HLM 0.54)]. FS Date: 4/4/2014

WS view: CM pipe, flapgate, and concrete headwall on levee slope.

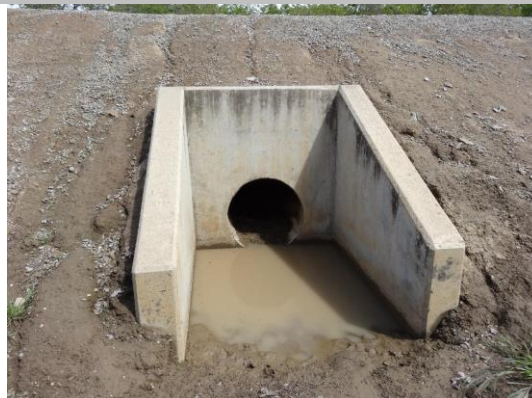
Photo 2 of 3 : UCIP_FA_2019_33114_59897.jpg

LS view: CM pipe, inlet box, and concrete headwall on levee slope.

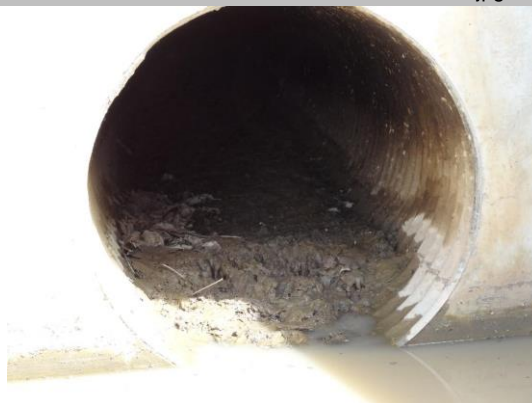
Photo 3 of 3 : UCIP_FA_2019_33114_59899.jpg

LS view: closer view of CM pipe. May need to clean and clear mud from the pipe.
