**Flood Control Project Maintenance
Levee Inspections**

Maintenance Issue Types Only, Levee Inspection Report By Mile - Fall 2020

San Joaquin County Flood Control and Water Conservation District

Waterway	Bank	Unit Miles	Inspection Start/End	Inspector
Unit No. 01 Littlejohn Creek	Left	2.59	10/20/2020 10/20/2020	Alberto De Leon

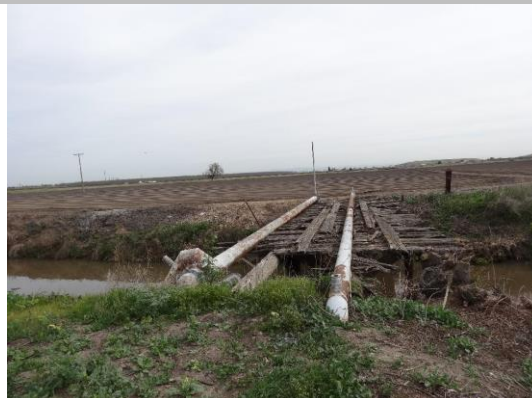
Photo 1 of 3 : UCIP_FA_2020_32744_59245.jpg

Comment Code						
Inspector Comment						
DS_ID:23992						
FS_ID:32744						
EP_NO: N/A						
Repair Type: No Action Needed						
EVAL Issue:						
Crossing Status: Found						
UCIP Comments: One 4-inch pvc pipe on the waterside levee slope. It is not clear whether the pvc pipe goes through the levee. One air vent on waterside and another across the channel. Water filter plant on landside. Not found : 24-inch CMP through levee and with flap gate. On landside a vertical pump on wooden structure; walkway to the pump; service pole and switch box. Pump is connected to 8-inch steel pipe for about 100 ft. 24-inch CMP continues through the levee. FIELD_STRUCT_DESC: 8-inch steel storm drainage pipe through the levee, 2 feet below the crown. Pipe goes over the top of the channel on a wood structure. One air vent on the waterside (WS) and another across the channel. Water filter plant on the landside (LS). [Additional Reference(s): DWR Levee Log, 1977, listed as a 14-inch pipe. USACE San Joaquin O&M Manual 613C, Volume 15, May 1963, (Station 131+25 ""S""), listed as a 24-inch corrugated metal pipe (CMP) with a flap gate].

WS view: two steel pipes through the levee and over Little John's Creek on wooden structure.

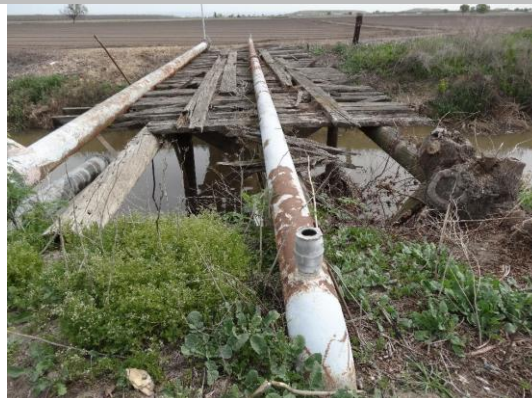
Photo 2 of 3 : UCIP_FA_2020_32744_59244.jpg

WS view: 8-inch steel pipe (right) and 12-inch steel pipe (left) over Little John's Creek on wooden structure.

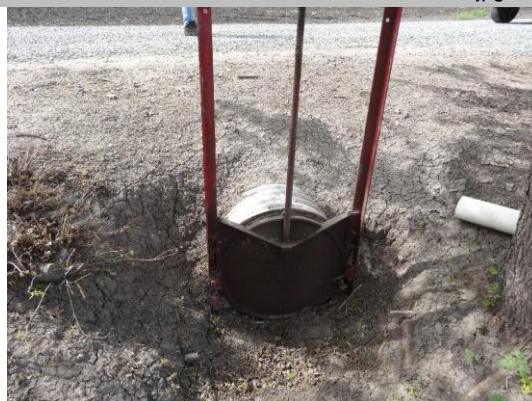
Photo 1 of 3 : UCIP_FA_2020_53494_59248.jpg

Comment Code					
Inspector Comment					
DS_ID:17973 FS_ID:53494 EP_NO: N/A Repair Type: Urgent EVAL Issue: Crossing Status: Found UCIP Comments: 11/02/2018 Inlet deformed. Outlet missing a slide gate. The LMA states that a new slide gate will be installed in about two weeks. Inlet and outlet have dirt and vegetation issues. Crossing remains "Urgent" until a new slide gate is installed. Contact the LMA to see if they have photographic evidence that a new slide gate was put in. (A. McDonald - DWR UCIP)10/18/2018 Inlet deformed. Outlet missing a slide gate. This means that the pipe cannot be closed during high water. I have escalated this crossing from "No Action Needed" to "Urgent" due to the straight through pipe which could cause flooding during high water. There is a hole in the inlet, due to the deformity. It was most likely ran over by heavy equipment. I do not see enough evidence for an internal pipe inspection. (A. McDonald - DWR UCIP)03/25/2014 May need cleaning of mud in inlet pipe. (W. Wylie - DWR UCIP) FIELD_STRUCT_DESC: 24-inch corrugated metal drainage culvert through the levee, 4.2 feet below the crown. Slide gate on the waterside (WS) end, not found on 10/18/2018. [Additional Reference(s): DWR Levee Log, 1977. USACE San Joaquin O&M Manual 613C, Volume 15, May 1963, (Station 98+65)]. FS Date: 11/2/2018 2:54:00 PM

WS view: CMP outlet with slide gate on the WS slope.

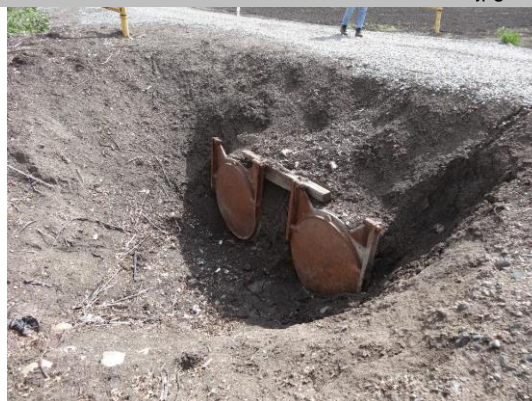
Photo 2 of 3 : UCIP_FA_2020_53461_59185.jpg

WS view: CMP drain pipes with flap gates on ditch.

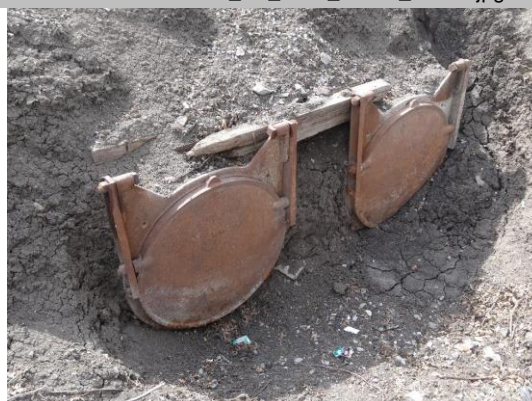
Photo 3 of 3 : UCIP_FA_2020_53461_59184.jpg

WS view: closer view of CMP drain pipes with flap gates on ditch. Right flap gate was blocked by soil/mud.

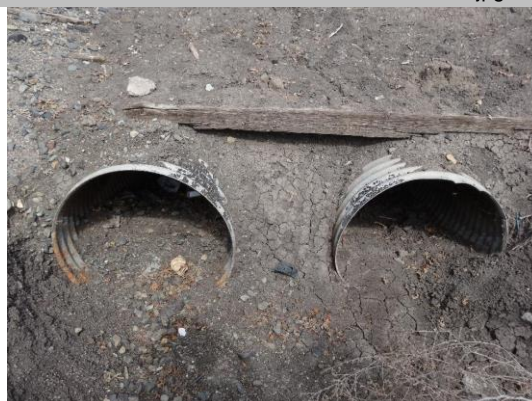
Photo 3 of 3 : UCIP_FA_2020_53130_59189.jpg

LS view: CMP inlet pipes on levee slope. Debris and mud on inlet ditch and inside the pipe.

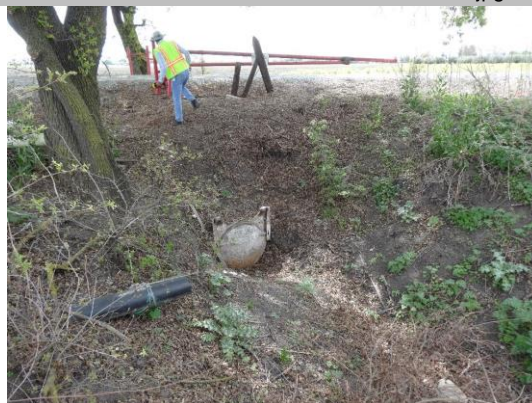
Photo 1 of 3 : UCIP_FA_2020_53459_59251.jpg

DS_ID:23985
 FS_ID:53459
 EP_NO: N/A
 Repair Type: No Action Needed
 EVAL Issue:
 Crossing Status: Found
 UCIP Comments: 11/02/2018 Inlet and outlet cleared of dirt and vegetation by the LMA. Crossing has been downgraded to "No Action Needed." (A. McDonald - DWR UCIP)03/25/2014 Debris and mud on inlet ditch and inside pipe. Needs cleaning and clearing the culvert. (P. Amatya - DWR UCIP)
 FIELD_STRUCT_DESC: 30-inch corrugated metal drainage pipe through the levee, 11 feet below the crown. Flap gate on the waterside (WS). [Additional Reference(s): USACE San Joaquin O&M Manual 613C, Volume 15, May 1963, (Station 83+00)].
 FS Date: 11/2/2018 2:31:00 PM

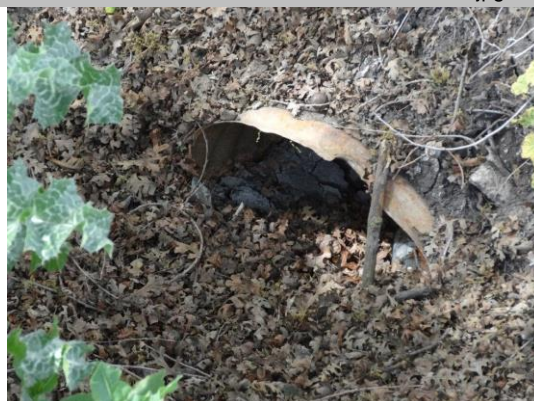
Photo 2 of 3 : UCIP_FA_2020_53459_59250.jpg

LS view: CMP inlet pipe on levee slope. Vegetation debris and mud on inlet ditch.

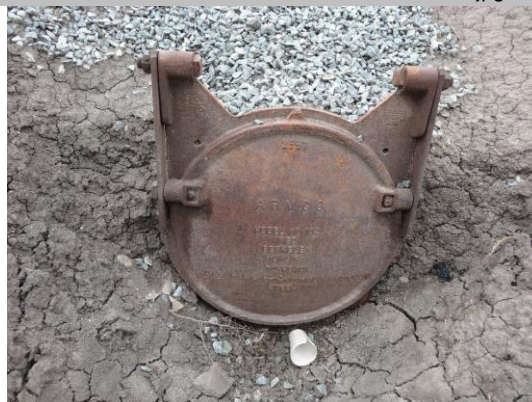
Photo 2 of 3 : UCIP_FA_2020_53458_59253.jpg

WS view: closer view of CM drain pipe with flap gate on levee slope.

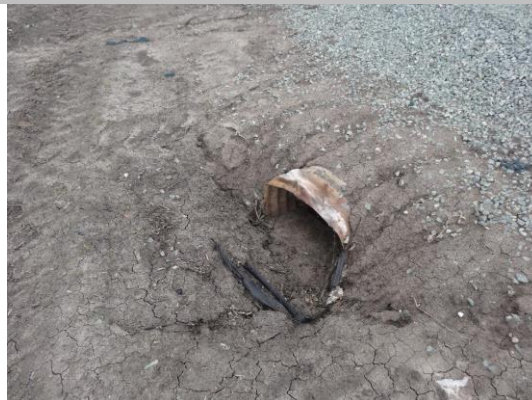
Photo 3 of 3 : UCIP_FA_2020_53458_59252.jpg

LS view: deformed CM inlet pipe on levee slope. Debris and mud on inlet ditch.

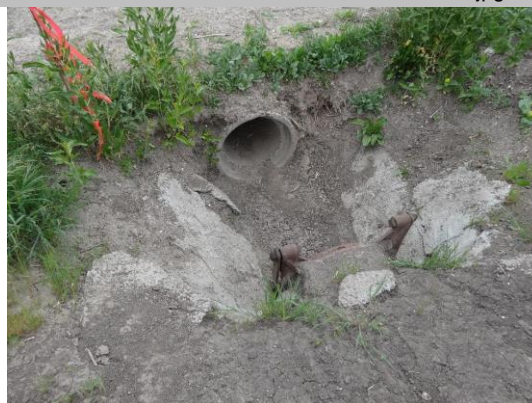
Photo 1 of 3 : UCIP_FA_2020_53462_59121.jpg

Comment Code						
Inspector Comment						
DS_ID:17966 FS_ID:53462 EP_NO: N/A Repair Type: No Action Needed EVAL Issue: Crossing Status: Found UCIP Comments: 11/02/2018 Inlet uncovered from the dirt by the LMA. Some vegetation at the flap gate. Crossing continues to be rated "No Action Needed." (A. McDonald - DWR UCIP)03/25/2014 Grouted riprap outlet box and concrete outfall pipe on waterside. Pipe not visible on landside. (P. Amatya - DWR UCIP) FIELD_STRUCT_DESC: 24-inch corrugated metal drainage pipe through the levee, 5 feet below the crown. Flap gate on the waterside (WS) end. Grouted riprap outlet box and concrete outfall pipe on the WS. [Additional Reference(s): DWR Levee Log, 1977. USACE San Joaquin O&M Manual 613C, Volume 15, May 1963, (Station 4+00)]. FS Date: 11/2/2018 3:43:00 PM

WS view: outlet box, CMP with flapgate (bottom), and concrete outfall pipe (Top).

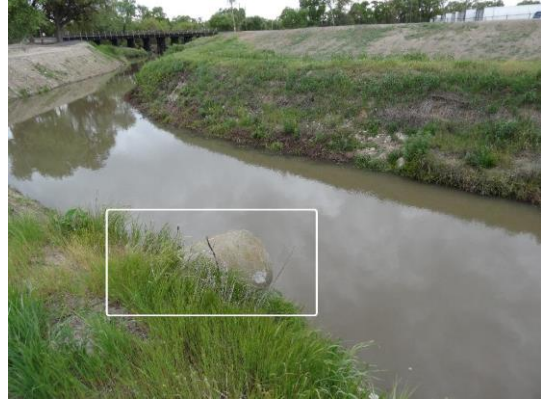
Photo 3 of 3 : UCIP_FA_2020_53462_59122.jpg

WS view: concrete outfall pipe on creek bank.

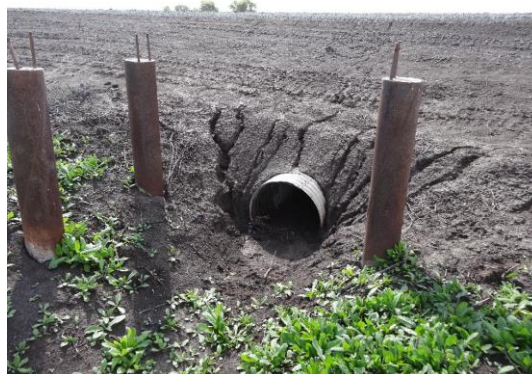
Photo 2 of 3 : UCIP_FA_2020_53457_59930.jpg

LS view: CM inlet pipe on levee slope. Mud on inlet ditch and pipe.

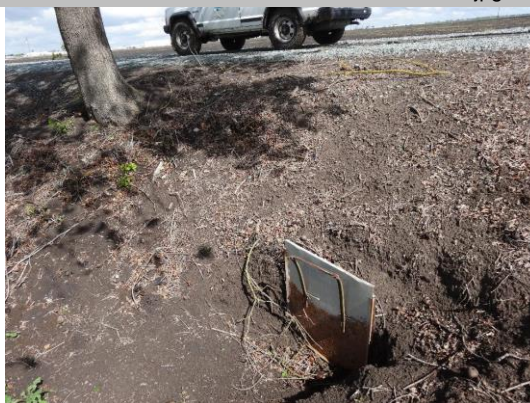
Photo 1 of 3 : UCIP_FA_2020_53453_59937.jpg

Comment Code						
Inspector Comment						
DS_ID:17983 FS_ID:53453 EP_NO: N/A Repair Type: No Action Needed EVAL Issue: Crossing Status: Found UCIP Comments: 11/02/2018 Inlet and outlet cleared of dirt and vegetation by the LMA. Crossing has been downgraded to "No Action Needed." (A. McDonald - DWR UCIP)04/02/2014 Needs cleaning and clearing the culvert. (P. Amatya - DWR UCIP) FIELD_STRUCT_DESC: 24-inch corrugated metal drainage pipe through the levee, 6.4 feet below the crown. Flap gate on the waterside (WS) end. [Additional Reference(s): DWR Levee Log, 1977. USACE San Joaquin O&M Manual 613C, Volume 15, May 1963, (Station 114+50)]. FS Date: 11/2/2018 11:37:00 AM

WS view: CM drain pipe with plate gate on levee slope.

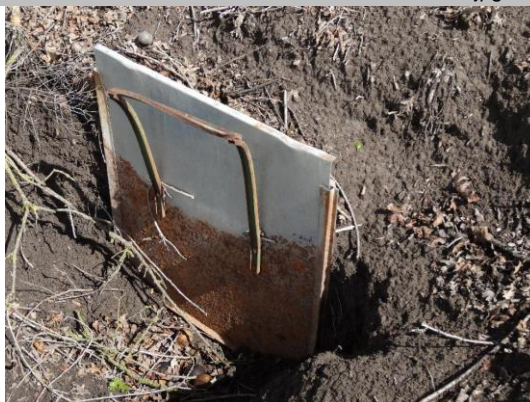
Photo 2 of 3 : UCIP_FA_2020_53453_59936.jpg

WS view: closer view of plate gate on the CM pipe end.

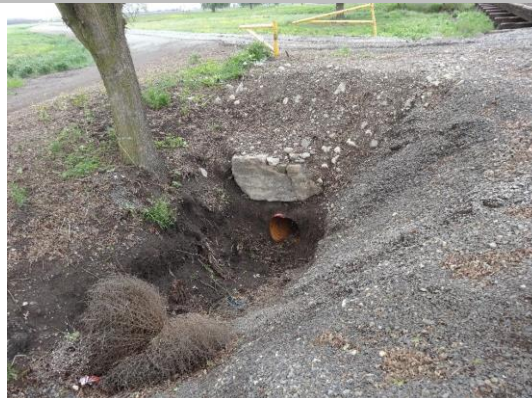
Photo 2 of 3 : UCIP_FA_2020_53455_59946.jpg

LS view: CM drain pipe on drainage ditch. Mud and vegetation debris on the pipe.

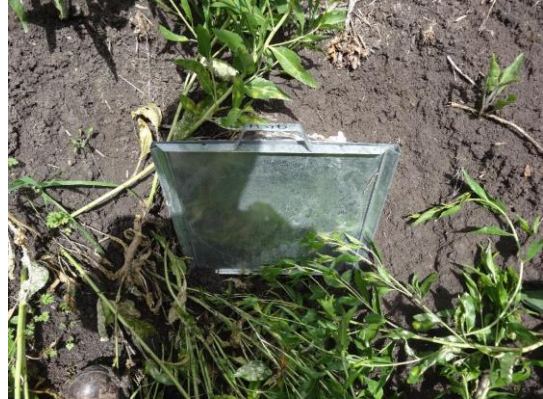
Photo 2 of 3 : UCIP_FA_2020_53452_59951.jpg

WS view: closer view of galvanized iron plate slide gate on HDPE pipe end.

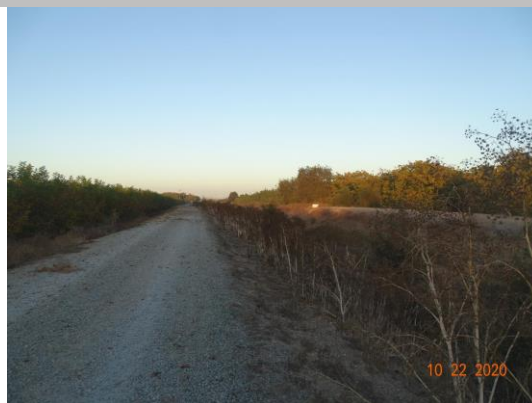
Photo 1 of 1 : FA_2020_NA0017_150_2_20201022_00004.jpg

LM Start	0.34	Rating **	M	Issue No.	2
LM End	0.46	Issue Type +	Ma	Location *	WS
Category	Earthen Levee			GPS Latitude/Longitude	
				Start	End
Item	Vegetation			37.979252 °	37.979307 °
				-121.092743 °	-121.090486 °
DWR ID	DWR_NA0017_06_f_2020_2				
Comment Code					
V1 : Control annual grass and weeds on the levee slopes and easements.					
Inspector Comment

Typical view of vegetation on waterside slope. Fall 2020

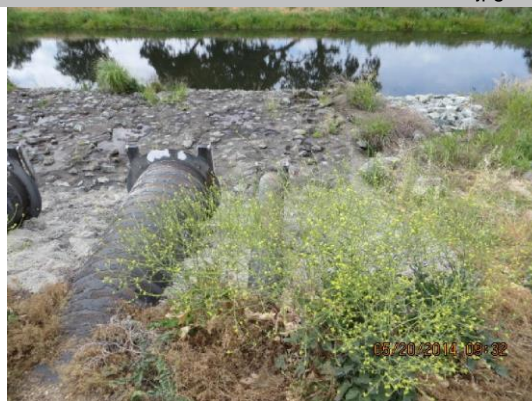
Photo 1 of 2 : UCIP_FA_2020_38092_69303.jpg

LM Start	1.33	Rating **	A/W	Issue No.	1054	
LM End	1.33	Issue Type +	Ma	Location *		
Category	Supplemental			GPS Latitude/Longitude		
				Start		End
Item	DWR UCIP LMA Responsibility			38.043286 °	38.043286 °	
				-121.349368 °	-121.349368 °	
DWR ID	23695					
Comment Code						
Inspector Comment						
DS_ID:23695						
FS_ID:38092						
EP_NO: N/A						
Repair Type: No Action Needed						
EVAL Issue:						
Crossing Status: Found						
UCIP Comments:						
FIELD_STRUCT_DESC: [Thornton Road Pump Station] 1 of 6: 12-inch wrapped steel storm drainage pipe through the levee, approximately 3 feet below the crown. Pump station on the landside (LS). Flap gate on the waterside (WS) end. [Additional Reference(s): USACE San Joaquin O&M Manual 612 (addendum), February 1999, (HLM 2.16) (Station 114+25)].						
FS Date: 5/20/2014

Pipe and flapgate visible on WS slope.

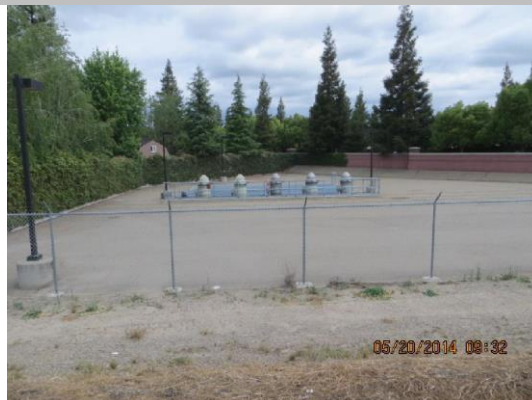
Photo 2 of 2 : UCIP_FA_2020_38092_69302.jpg

Pump over sump off LS toe.

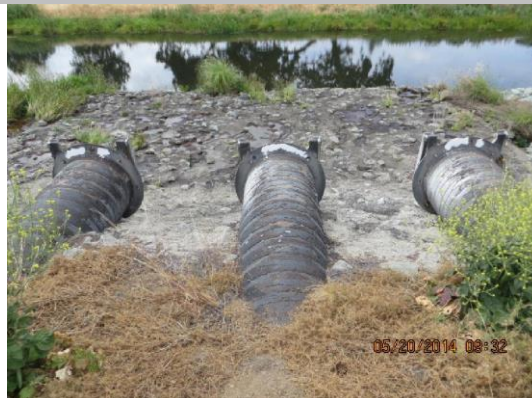
Photo 1 of 2 : UCIP_FA_2020_38086_69291.jpg

LM Start	1.33	Rating **	A/W	Issue No.	1056	
LM End	1.33	Issue Type +	Ma	Location *		
Category	Supplemental			GPS Latitude/Longitude		
				Start		End
Item	DWR UCIP LMA Responsibility			38.043291 °	38.043291 °	
				-121.349327 °	-121.349327 °	
DWR ID	23691					
Comment Code						
Inspector Comment						
DS_ID:23691						
FS_ID:38086						
EP_NO: N/A						
Repair Type: No Action Needed						
EVAL Issue:						
Crossing Status: Found						
UCIP Comments:						
FIELD_STRUCT_DESC: [Thornton Road Pump Station] 3 of 6: 36-inch wrapped steel storm drainage pipe through the levee, approximately 3 feet below the crown. Pump station on the landside (LS). Flap gate on the waterside (WS) end. [Additional Reference(s): USACE San Joaquin O&M Manual 612 (addendum), February 1999, (HLM 2.16) (Station 114+25)].						
FS Date: 5/20/2014

Pipe and flapgate visible on WS slope.

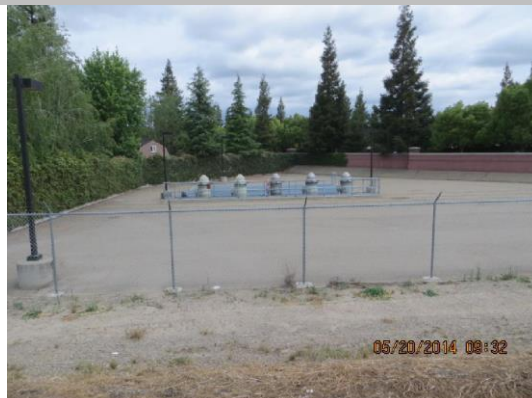
Photo 2 of 2 : UCIP_FA_2020_38087_69292.jpg

Pump over sump off LS toe.

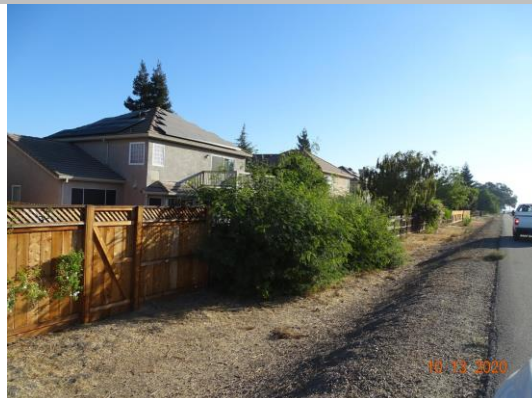
Photo 1 of 1 : FA_2020_NA0017_151_155_20201019_00332.jpg

LM Start	2.13	Rating **	U	Issue No.	155
LM End	2.13	Issue Type +	Ma	Location *	LS
Category	Earthen Levee			GPS Latitude/Longitude	
				Start	End
Item	Vegetation			38.043209 °	38.043209 °
				-121.334599 °	-121.334599 °
DWR ID	DWR_NA0017_07_f_2020_155				
Comment Code					
V2 : Remove the wild growth other than native grasses from the levee slopes.					
Inspector Comment

View of heavy vegetation within the landside easement. Fall 2020

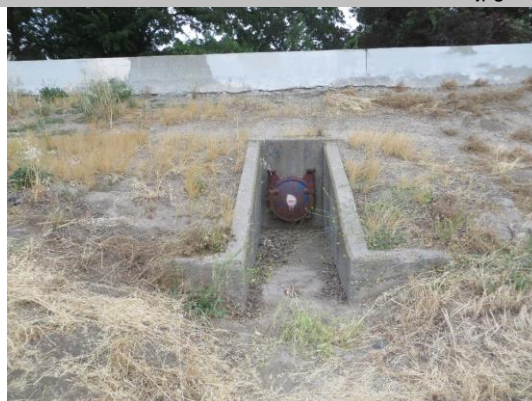
Photo 1 of 3 : UCIP_FA_2020_38024_69205.jpg

LM Start	2.31	Rating **	A/W	Issue No.	1065	
LM End	2.31	Issue Type +	Ma	Location *		
Category	Supplemental			GPS Latitude/Longitude		
				Start	End	
Item	DWR UCIP LMA Responsibility			38.043195 °	38.043195 °	
				-121.331260 °	-121.331260 °	
DWR ID	23522					
Comment Code						
Inspector Comment						
DS_ID:23522 FS_ID:38024 EP_NO: N/A Repair Type: No Action Needed EVAL Issue: Crossing Status: Found UCIP Comments: FIELD_STRUCT_DESC: 24-inch corrugated metal drainage pipe through the levee, 5.5 feet below the crown. Concrete U-shaped headwalls on both ends. Flap gate on the waterside (WS) end. Cobble grouted spillway across the berm. [Additional Reference(s): DWR Levee Log, 1987. USACE San Joaquin O&M Manual 612.1, June 1965, (HLM 2.59)]. FS Date: 5/20/2014

Headwall and flapgate on WS toe.

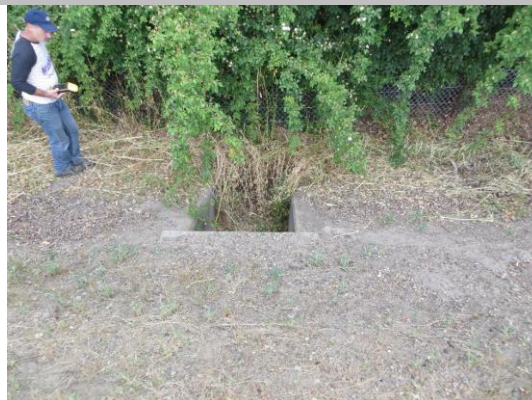
Photo 2 of 3 : UCIP_FA_2020_38024_69204.jpg

Headwall at LS toe.

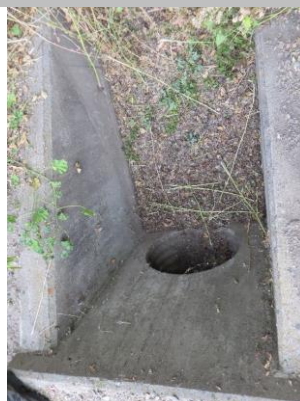
Photo 3 of 3 : UCIP_FA_2020_38024_69203.jpg

Headwall at LS toe.

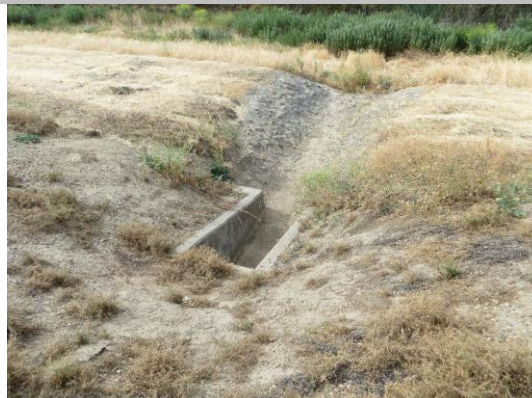
Photo 1 of 3 : UCIP_FA_2020_38006_69190.jpg

LM Start	2.64	Rating **	A/W	Issue No.	1066	
LM End	2.64	Issue Type +	Ma	Location *		
Category	Supplemental			GPS Latitude/Longitude		
				Start		End
Item	DWR UCIP LMA Responsibility			38.043146 °		38.043146 °
				-121.325350 °		-121.325350 °
DWR ID	23523					
Comment Code						
Inspector Comment						
DS_ID:23523 FS_ID:38006 EP_NO: N/A Repair Type: No Action Needed EVAL Issue: Crossing Status: Found UCIP Comments: FIELD_STRUCT_DESC: 24-inch corrugated metal drainage pipe through the levee, 10 feet below the crown. Concrete U-shaped headwalls on both ends. Flap gate on the waterside (WS) end. Cobble grouted spillway across berm. [Additional Reference(s): DWR Levee Log, 1987. USACE San Joaquin O&M Manual 612.1, June 1965, (HLM 2.82)]. FS Date: 5/20/2014

Headwall, flapgate, and grouted spillway on WS toe.

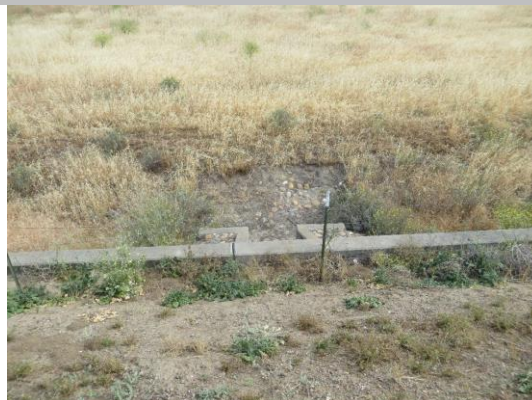
Photo 2 of 3 : UCIP_FA_2020_38006_69189.jpg

Headwall at inlet on LS toe.

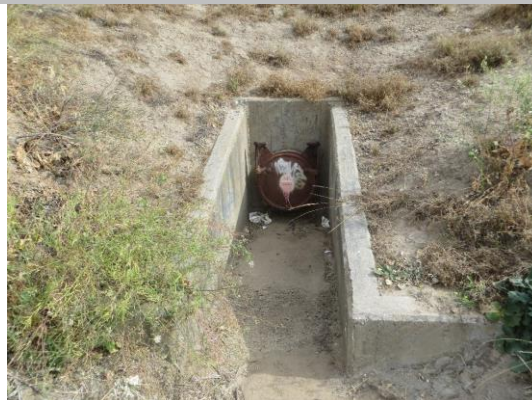
Photo 3 of 3 : UCIP_FA_2020_38006_69188.jpg

Headwall and flapgate at WS toe.

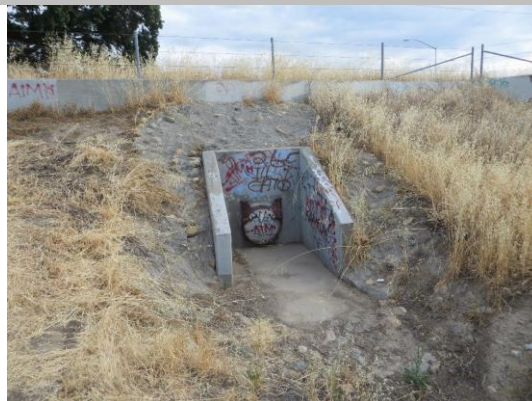
Photo 1 of 3 : UCIP_FA_2020_38004_69184.jpg

DS_ID:23525
 FS_ID:38004
 EP_NO: N/A
 Repair Type: No Action Needed
 EVAL Issue:
 Crossing Status: Found
 UCIP Comments:
 FIELD_STRUCT_DESC: 24-inch corrugated metal drainage pipe through the levee, 8 feet below the crown. Concrete U-shaped headwalls on both ends. Flap gate on the waterside (WS) end. Cobble grouted spillway across the berm. [Additional Reference(s): DWR Levee Log, 1987. USACE San Joaquin O&M Manual 612.1, June 1965, (HLM 3.09)].
 FS Date: 5/20/2014

Headwall and flapgate on WS slope.

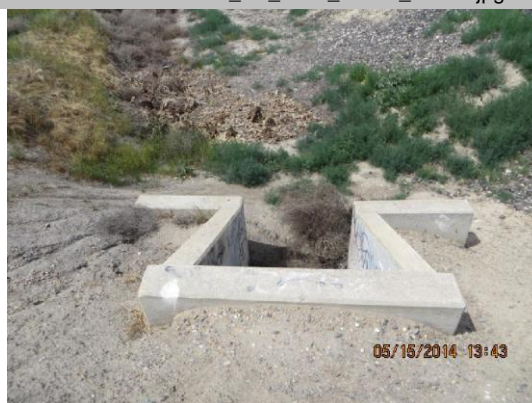
Photo 1 of 3 : UCIP_FA_2020_37998_69160.jpg

DS_ID:23528
 FS_ID:37998
 EP_NO: N/A
 Repair Type: No Action Needed
 EVAL Issue:
 Crossing Status: Found
 UCIP Comments:
 FIELD_STRUCT_DESC: 42-inch corrugated metal drainage pipe through the levee, 7.3 feet below the crown. Concrete U-shaped headwall on both sides. Flap gate on the waterside (WS) end. Grouted intake on the landside (LS). Cobble grouted spillway across the berm. [Additional Reference(s): DWR Levee Log, 1987. USACE San Joaquin O&M Manual 612.1, June 1965, (HLM 3.36)].
 FS Date: 5/15/2014

Headwall on LS slope.

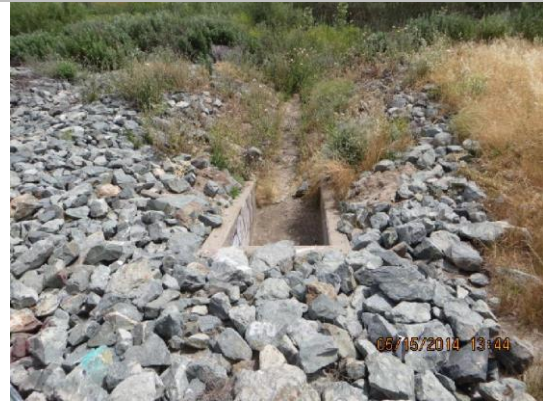
Photo 2 of 3 : UCIP_FA_2020_37998_69159.jpg

Headwall and flapgate on WS toe.

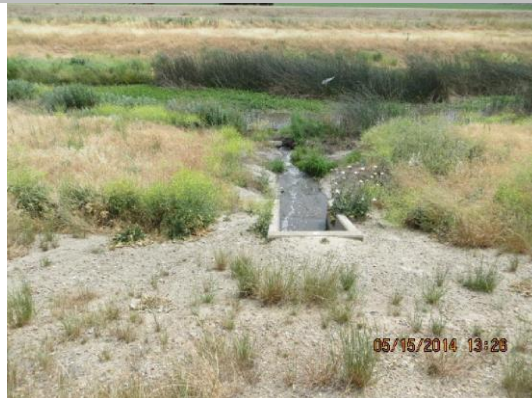
Photo 2 of 3 : UCIP_FA_2020_37991_69143.jpg

Headwall and flapgate at WS toe.

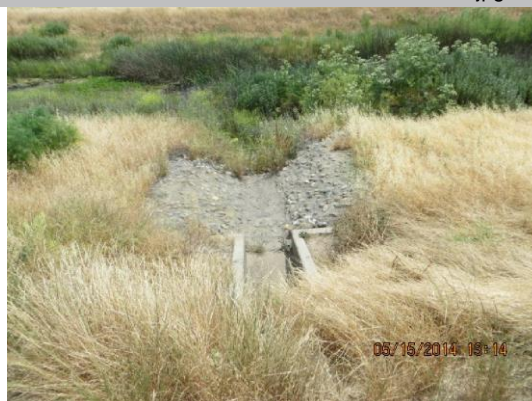
Photo 2 of 3 : UCIP_FA_2020_37988_69138.jpg

Headwall, flapgate, and grouted spillway on WS toe.

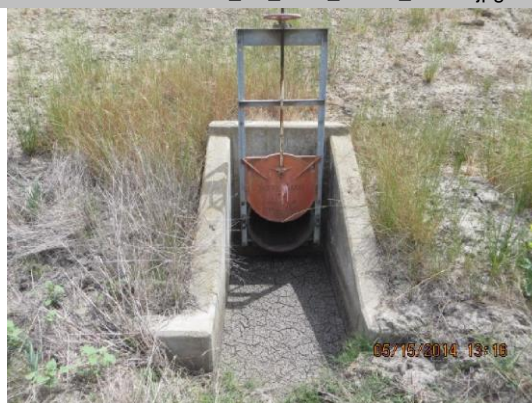
Photo 3 of 3 : UCIP_FA_2020_37988_69137.jpg

Headwall and slidegate on LS toe.

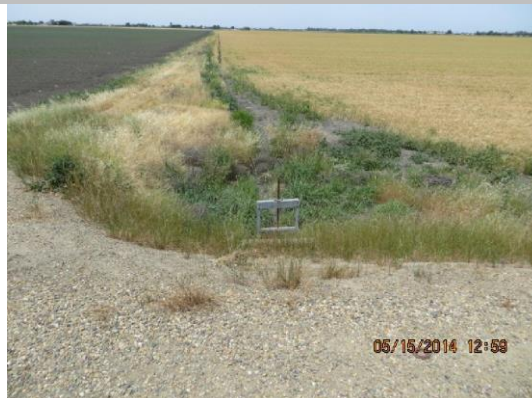
Photo 1 of 3 : UCIP_FA_2020_37984_69129.jpg

Slidegate at headwall on LS toe.

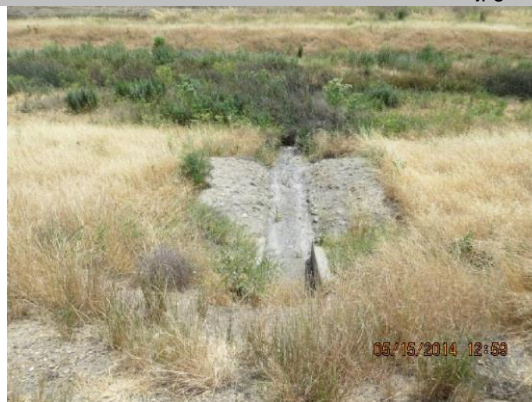
Photo 2 of 3 : UCIP_FA_2020_37984_69128.jpg

Headwall and flapgate at WS toe.

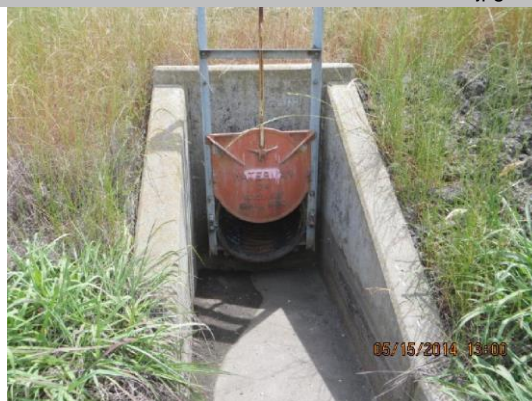
Photo 3 of 3 : UCIP_FA_2020_37984_69127.jpg

Slidegate at headwall on LS toe.

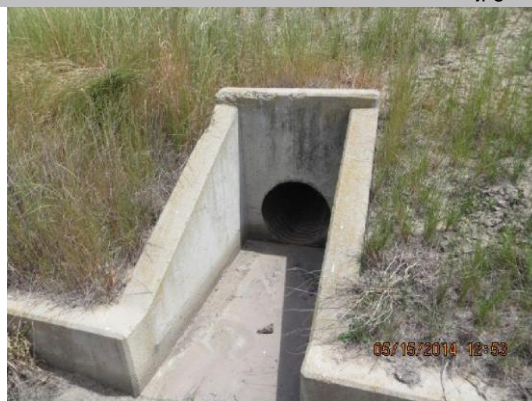
Photo 2 of 3 : UCIP_FA_2020_37982_69124.jpg

Headwall at LS toe.

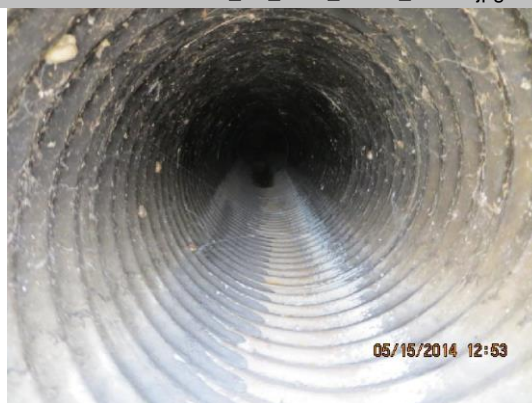
Photo 3 of 3 : UCIP_FA_2020_37982_69123.jpg

Inside pipe at LS toe.

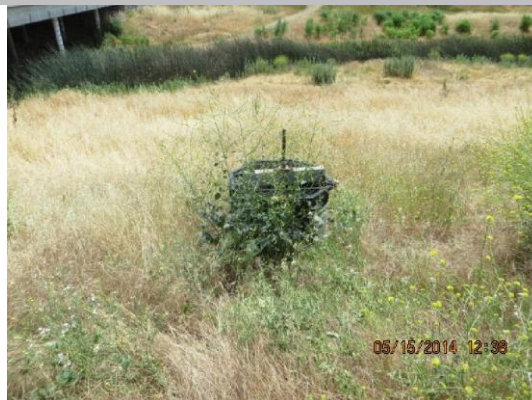
Photo 2 of 3 : UCIP_FA_2020_37981_69121.jpg

Slidegate in CMP riser on WS slope.

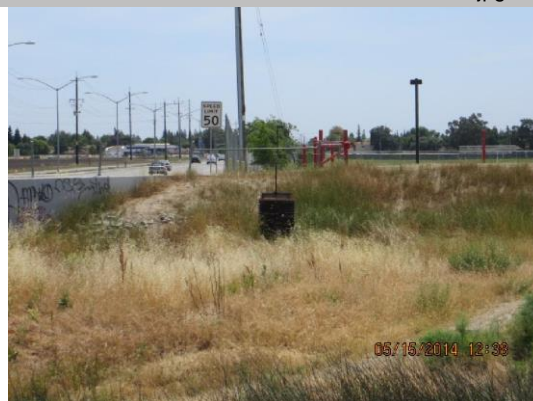
Photo 3 of 3 : UCIP_FA_2020_37981_69120.jpg

Adjoining CMP riser on opposite bank.

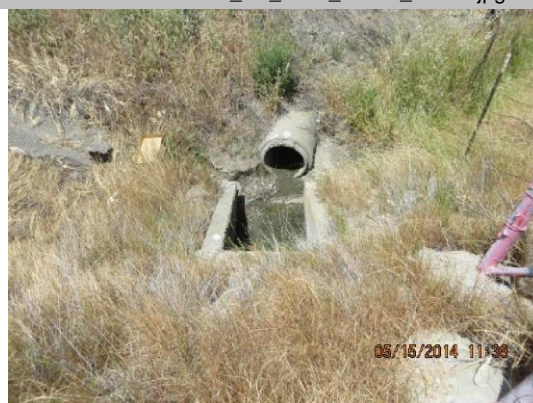
Photo 1 of 3 : UCIP_FA_2020_37973_69105.jpg

Headwall on LS toe.

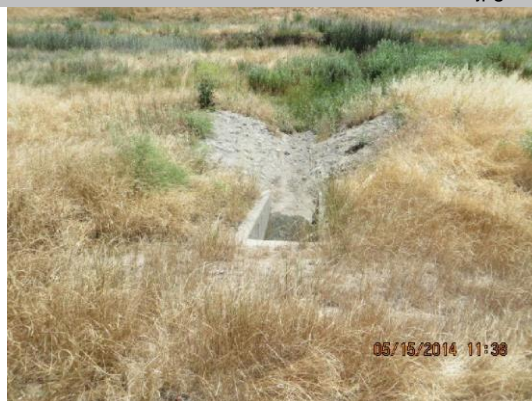
Photo 2 of 3 : UCIP_FA_2020_37973_69104.jpg

Headwall, flapgate, and grouted spillway on WS toe.

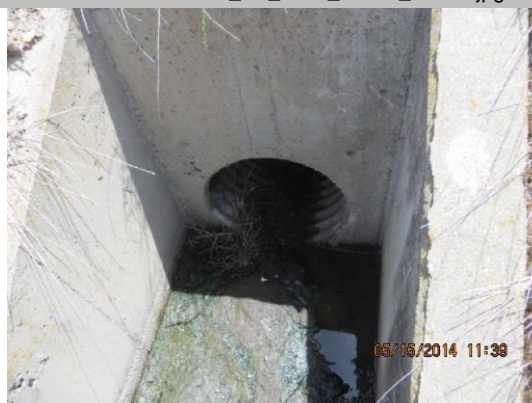
Photo 3 of 3 : UCIP_FA_2020_37973_69103.jpg

Headwall on LS toe.

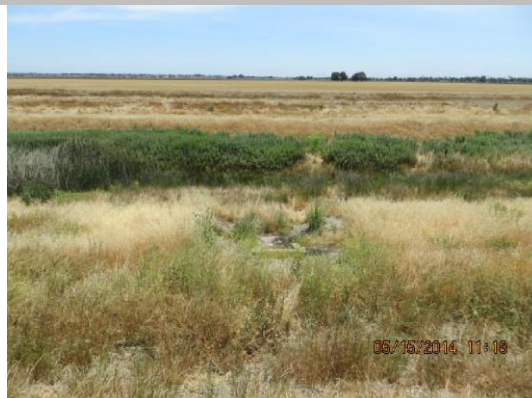
Photo 2 of 3 : UCIP_FA_2020_37967_69084.jpg

Headwall and flapgate on WS toe.

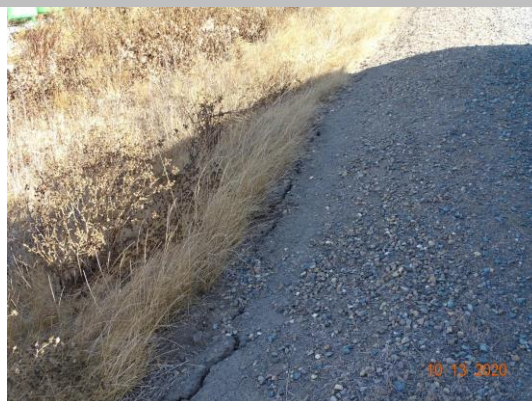
Photo 1 of 1 : FA_2020_NA0017_151_172_20201019_00338.jpg

LM Start	4.93	Rating **	M	Issue No.	172
LM End	4.93	Issue Type +	Ma	Location *	LS
Category	Earthen Levee			GPS Latitude/Longitude	
				Start	End
Item	Slope Stability			38.050186 °	38.050186 °
				-121.287173 °	-121.287173 °
DWR ID	DWR_NA0017_07_f_2020_172				
Comment Code					
S1 : Repair slope instability.					
Inspector Comment

View of soil separation along the landside shoulder. Fall 2020

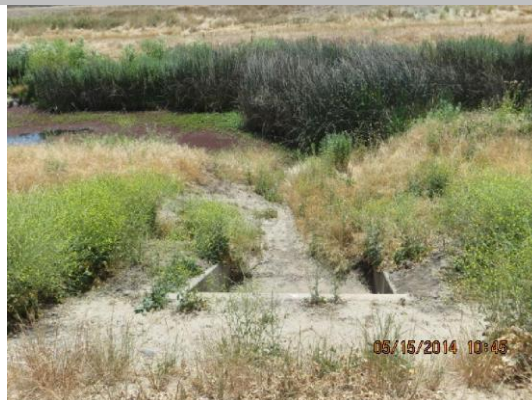
Photo 2 of 3 : UCIP_FA_2020_37957_69054.jpg

Headwall and flapgate on WS toe.

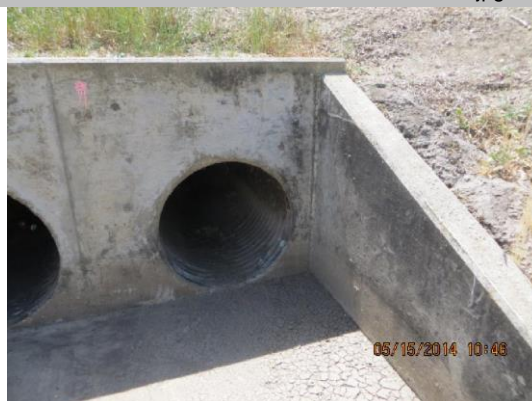
Photo 3 of 3 : UCIP_FA_2020_37957_69053.jpg

Headwall on LS toe.

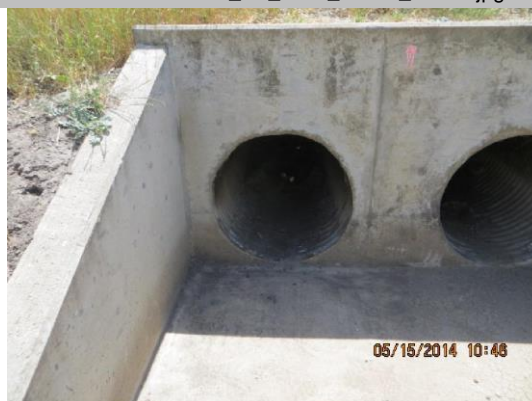
Photo 3 of 3 : UCIP_FA_2020_41807_69048.jpg

DS_ID:23678
 FS_ID:41807
 EP_NO: N/A
 Repair Type: Non-Urgent
 EVAL Issue:
 Crossing Status: Found
 UCIP Comments: Some silt buildup in pipe.
 FIELD_STRUCT_DESC: 2 of 2: 36-inch corrugated metal drainage pipe through the levee, 8.9 feet below the crown. Concrete U-shaped headwall on both ends. Flap gate on the waterside (WS) end. Grouted intake on the landside (LS). Cobble grouted spillway across the berm.
 [Additional Reference(s): DWR Levee Log, 1987. USACE San Joaquin O&M Manual 612.1, June 1965, (HLM 5.33)].
 FS Date: 5/15/2014

Headwall at LS toe.

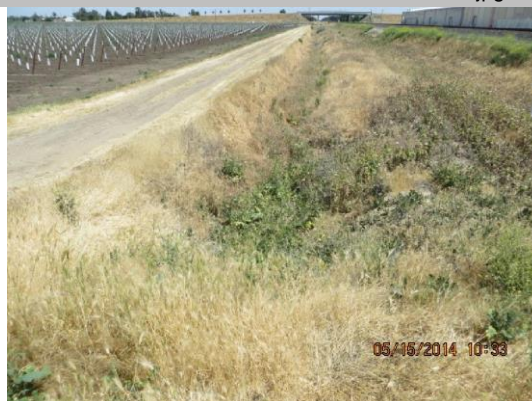
Photo 1 of 3 : UCIP_FA_2020_37885_68913.jpg

Pipe in channel on LS toe.

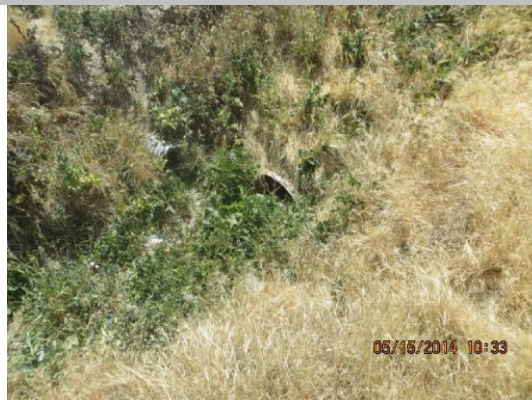
Photo 2 of 3 : UCIP_FA_2020_37885_68912.jpg

Pipe in channel on LS toe.

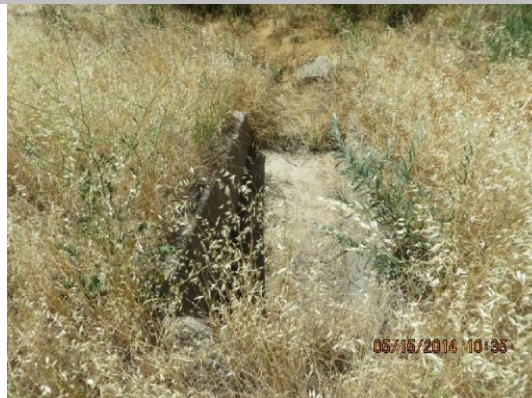
Photo 3 of 3 : UCIP_FA_2020_37885_68911.jpg

Flapgate and headwall at WS toe.

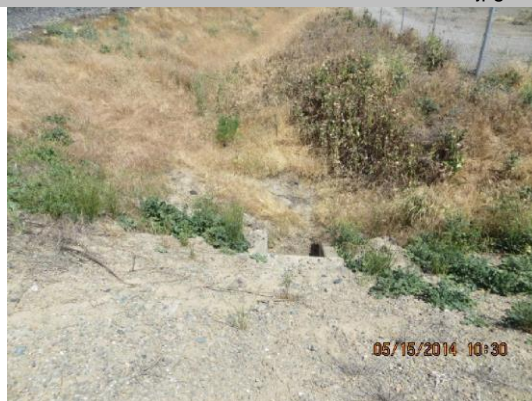
Photo 2 of 3 : UCIP_FA_2020_41801_68901.jpg

DS_ID:23545
 FS_ID:41801
 EP_NO: N/A
 Repair Type: Non-Urgent
 EVAL Issue:
 Crossing Status: Found
 UCIP Comments: Some sediment buildup inside pipe.
 FIELD_STRUCT_DESC: 24-inch corrugated metal drainage pipe through the levee, 6.9 feet below the crown. Concrete U-shaped headwalls on both ends. Flap gate on the waterside (WS) end. Grouted intake on the landside (LS). Cobble grouted spillway across berm.
 [Additional Reference(s): DWR Levee Log, 1987. USACE San Joaquin O&M Manual 612.1, June 1965, (HLM 5.90)].
 FS Date: 5/15/2014

Headwall on LS toe.

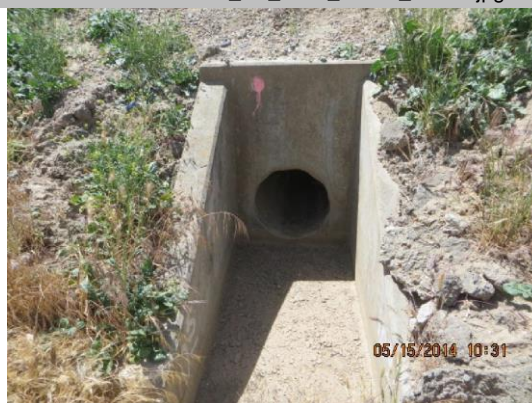
Photo 3 of 3 : UCIP_FA_2020_41801_68900.jpg

Headwall on LS toe.

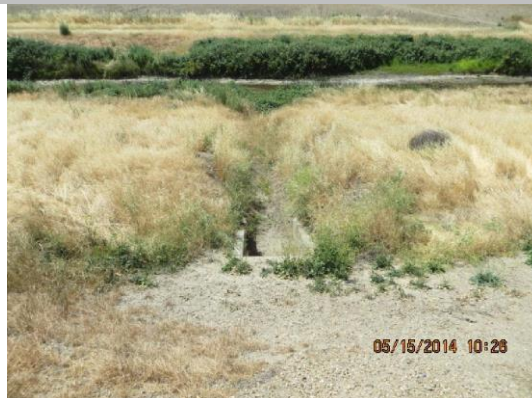
Photo 1 of 2 : UCIP_FA_2020_40213_68899.jpg

Comment Code						
Inspector Comment						
DS_ID:23546 FS_ID:40213 EP_NO: N/A Repair Type: Non-Urgent EVAL Issue: Crossing Status: Found UCIP Comments: Inlet burried at LS toe. Pipe may be abandoned and if so should be done so properly. FIELD_STRUCT_DESC: *ABANDONED* 36-inch corrugated metal drainage pipe through the levee, 7.9 feet below the crown. Concrete U-shaped headwall on the waterside (WS) end. Concrete headwall on the landside (LS). Flap gate on the WS end. Cobble grouted spillway across the berm. [Additional Reference(s): DWR Levee Log, 1987. USACE San Joaquin O&M Manual 612.1, June 1965, (HLM 5.97)]. FS Date: 5/15/2014

Headwall and flapgate at WS toe.

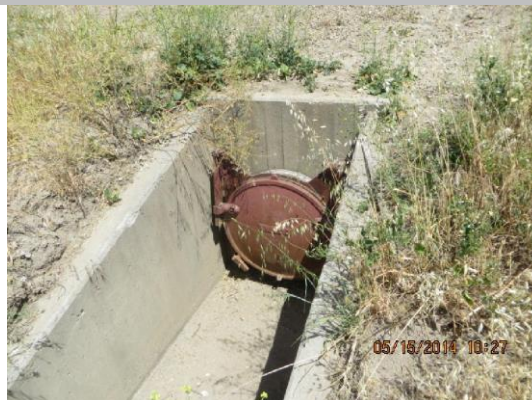
Photo 2 of 2 : UCIP_FA_2020_40213_68898.jpg

Headwall and flapgate at WS toe.

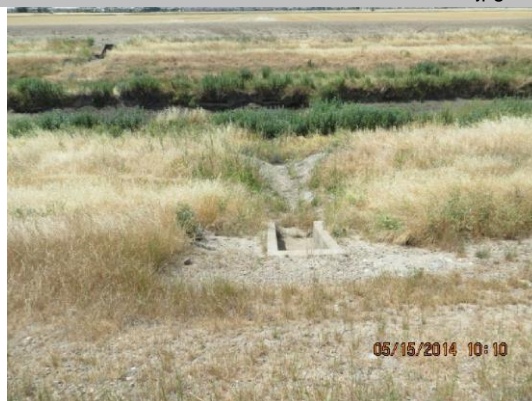
Photo 1 of 3 : UCIP_FA_2020_37874_68894.jpg

Headwall, flapgate, and grouted spillway on WS toe.

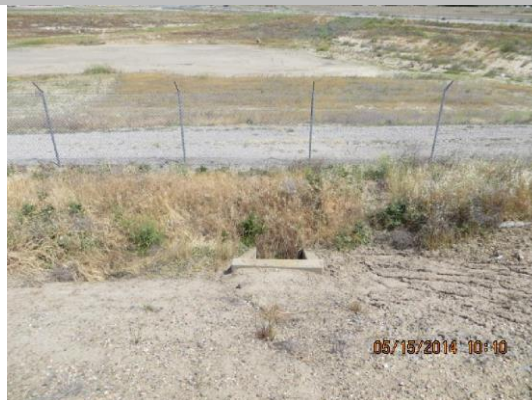
Photo 2 of 3 : UCIP_FA_2020_37874_68893.jpg

Headwall on LS toe.

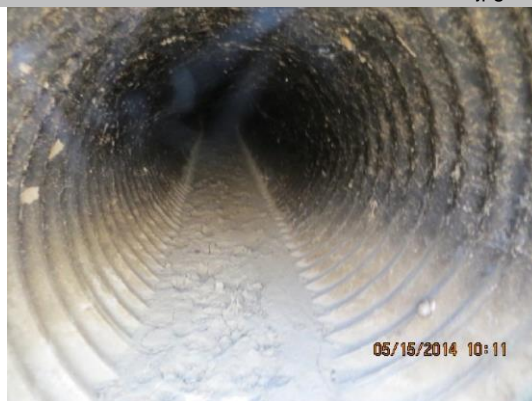
Photo 3 of 3 : UCIP_FA_2020_37874_68897.jpg

Inside pipe at LS toe. Note sediment buildup.

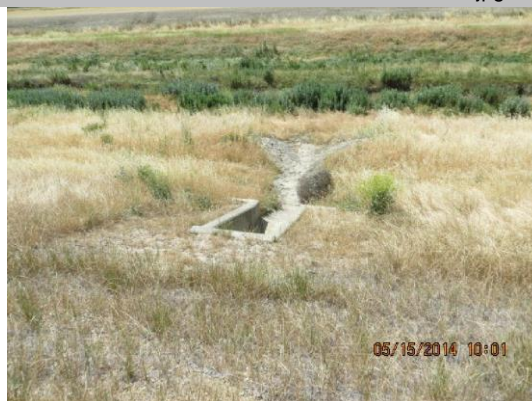
Photo 1 of 3 : UCIP_FA_2020_41802_68885.jpg

Comment Code						
Inspector Comment						
DS_ID:23551						
FS_ID:41802						
EP_NO: N/A						
Repair Type: Non-Urgent						
EVAL Issue:						
Crossing Status: Found						
UCIP Comments: Sediment buildup in pipe at LS toe.						
FIELD_STRUCT_DESC: 24-inch corrugated metal storm drainage pipe through the levee, 5.5 feet below the crown. Concrete U-shaped headwalls on both ends. Flap gate on the waterside (WS) end. Grouted intake on the landside (LS). Cobble grouted spillway across the berm. [Additional Reference(s): DWR Levee Log, 1987. USACE San Joaquin O&M Manual 612.1, June 1965, (HLM 6.32) and 612 (addendum), February 1999, (HLM 6.34) (Station 334+54), listed as a 36-inch pipe]. FS Date: 5/15/2014

Headwall and flapgate on WS toe.

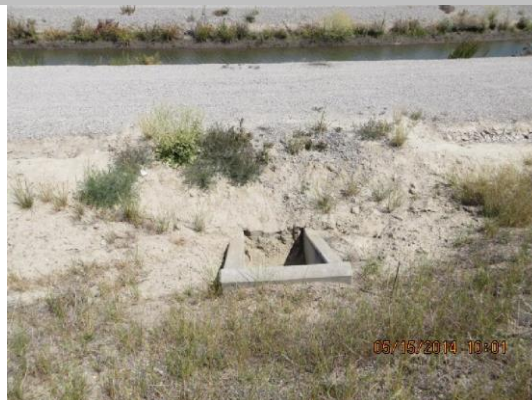
Photo 2 of 3 : UCIP_FA_2020_41802_68884.jpg

Headwall on LS toe.

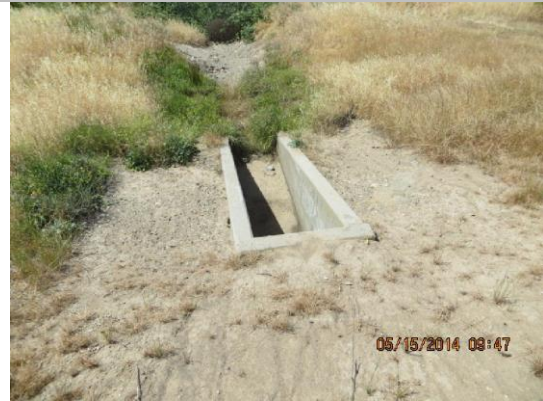
Photo 2 of 3 : UCIP_FA_2020_40208_68880.jpg

Flapgate and headwall on WS toe.

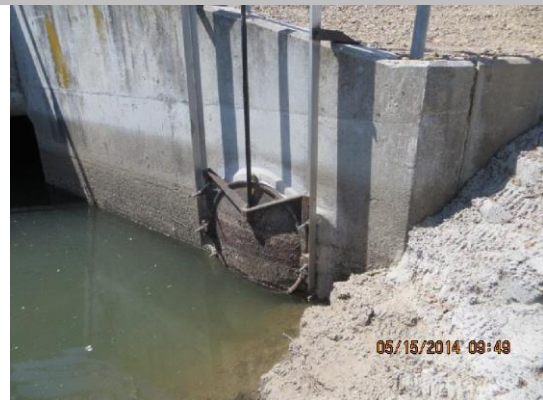
Photo 3 of 3 : UCIP_FA_2020_40208_68879.jpg

Slide gate on headwall at pipe on LS toe.

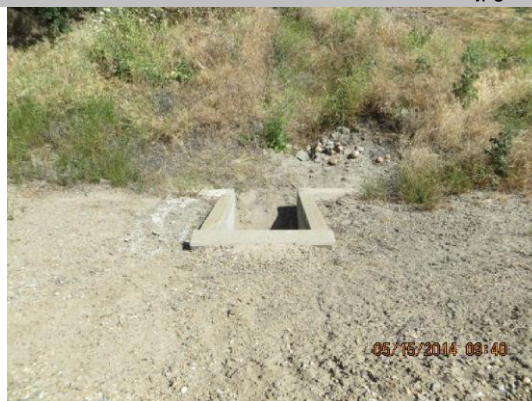
Photo 1 of 3 : UCIP_FA_2020_37852_68873.jpg

Headwall on LS toe.

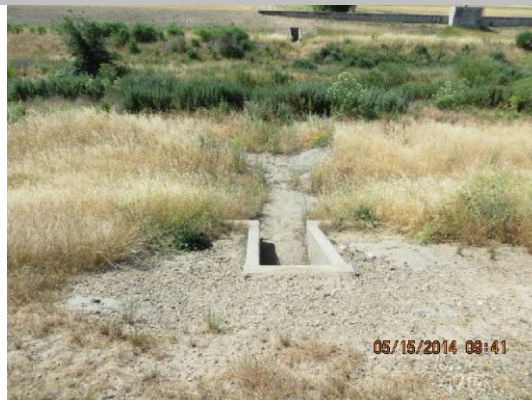
Photo 2 of 3 : UCIP_FA_2020_37852_68872.jpg

Headwall, flapgate, and grouted spillway on WS toe.

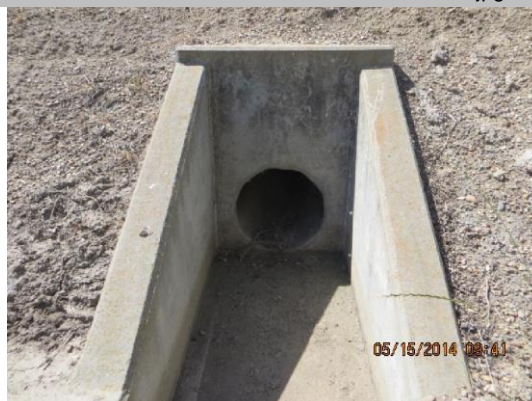
Photo 3 of 3 : UCIP_FA_2020_37852_68871.jpg

Headwall on LS toe.

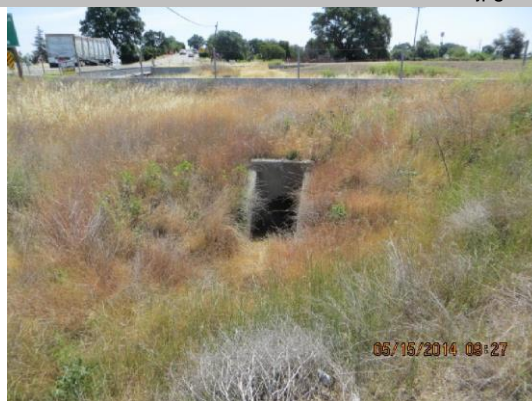
Photo 1 of 3 : UCIP_FA_2020_37849_68868.jpg

Pipe and headwall on LS toe.

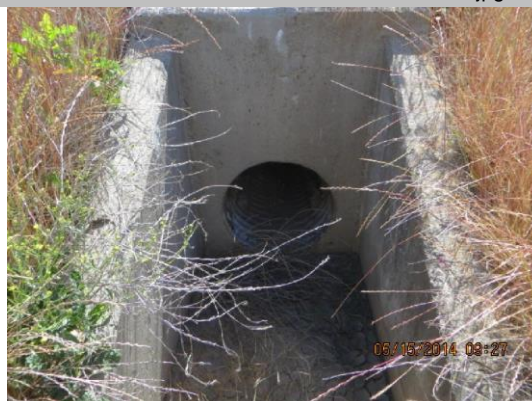
Photo 2 of 3 : UCIP_FA_2020_37849_68867.jpg

Pipe and headwall on LS toe.

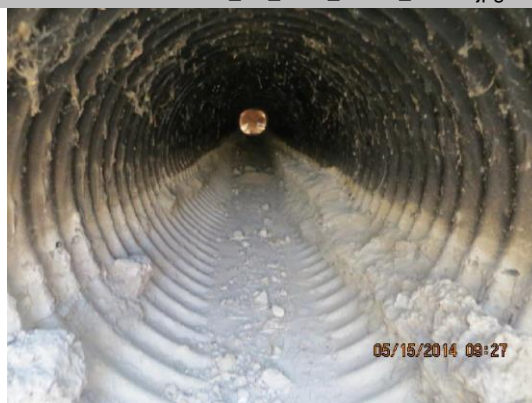
Photo 3 of 3 : UCIP_FA_2020_37849_68866.jpg

Inside pipe at LS toe.

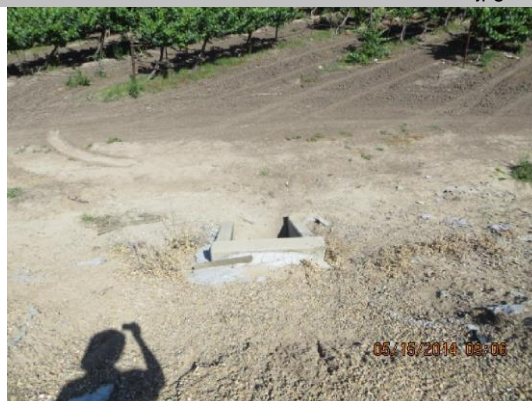
Photo 1 of 3 : UCIP_FA_2020_37847_68860.jpg

Pipe and headwall on LS toe.

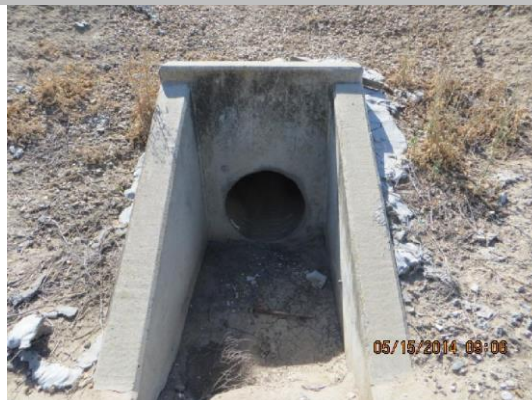
Photo 2 of 3 : UCIP_FA_2020_37847_68859.jpg

Pipe and headwall on LS toe.

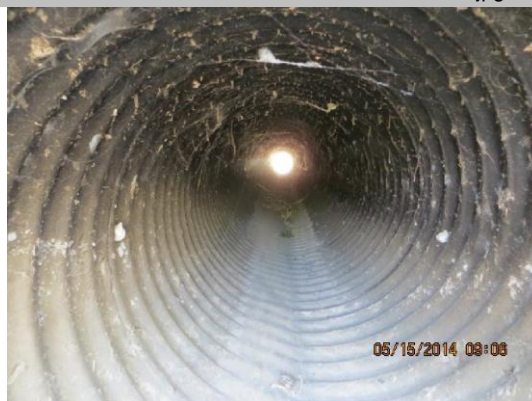
Photo 3 of 3 : UCIP_FA_2020_37847_68858.jpg

Inside pipe on LS toe.

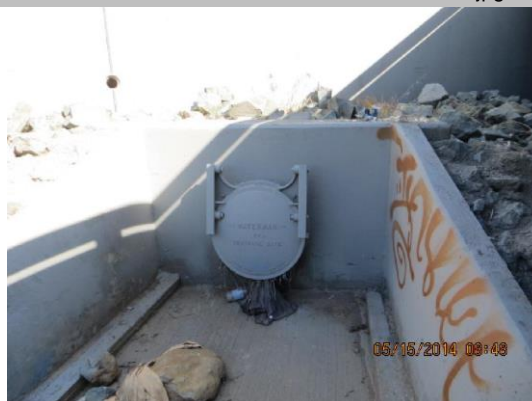
Photo 1 of 1 : UCIP_FA_2020_40207_68857.jpg

Pipe, headwall, and flapgate on WS toe.

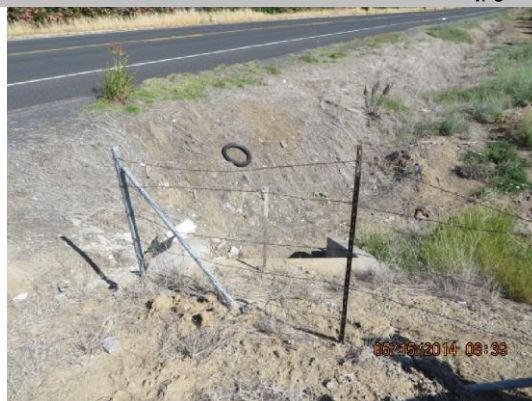
Photo 1 of 3 : UCIP_FA_2020_37844_68853.jpg

Pipe and headwall on LS toe.

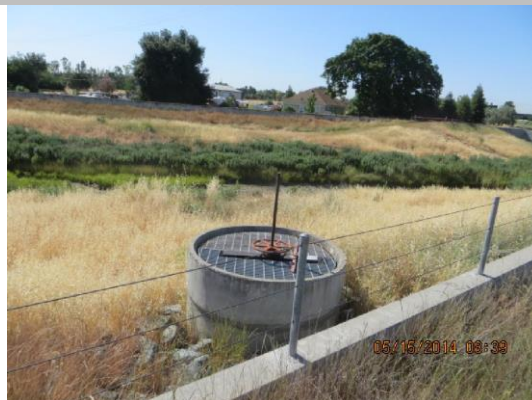
Photo 2 of 3 : UCIP_FA_2020_37844_68852.jpg

Slide gate in a 72-inch concrete riser on WS slope.

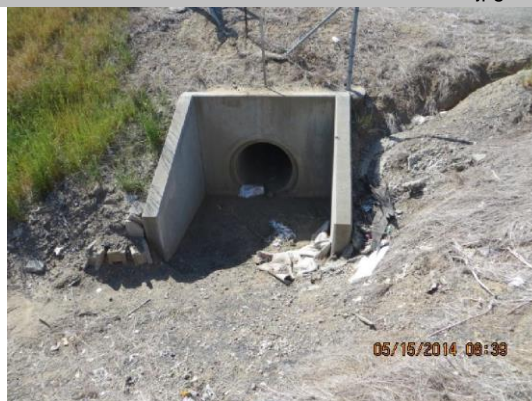
Photo 3 of 3 : UCIP_FA_2020_37844_68851.jpg

Pipe and headwall on LS toe.

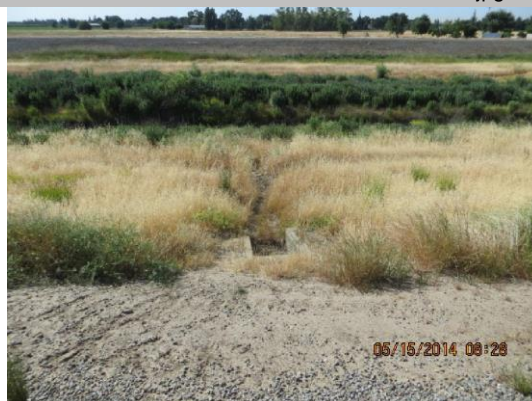
Photo 1 of 3 : UCIP_FA_2020_37842_68848.jpg

Headwall, pipe, flapgate, and grouted spillway on WS toe.

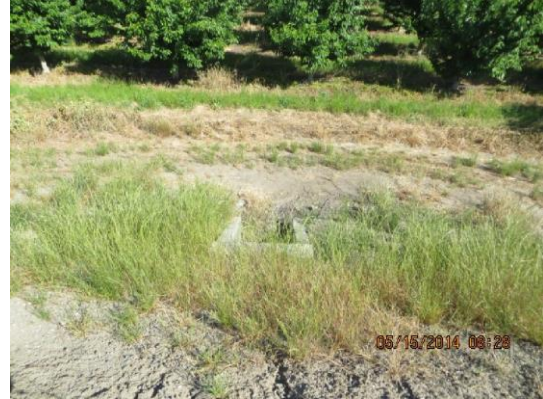
Photo 2 of 3 : UCIP_FA_2020_37842_68847.jpg

Pipe and headwall on LS toe.

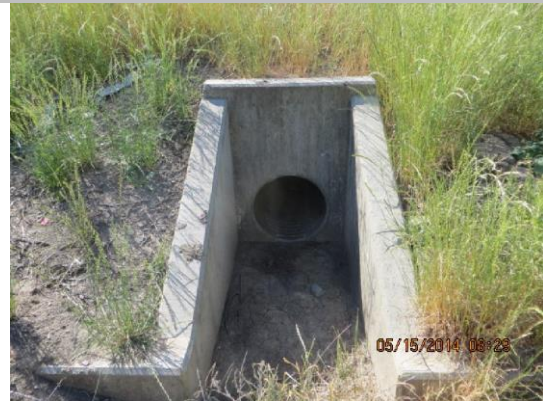
Photo 3 of 3 : UCIP_FA_2020_37842_68846.jpg

Pipe and headwall on LS toe.
