**Flood Control Project Maintenance
Levee Inspections**

Maintenance Issue Types Only, Levee Inspection Report By Mile - Fall 2020

San Joaquin County Flood Control and Water Conservation District

Waterway	Bank	Unit Miles	Inspection Start/End	Inspector
Unit No. 01 Littlejohn Creek	Left	2.59	10/20/2020 10/20/2020	Alberto De Leon

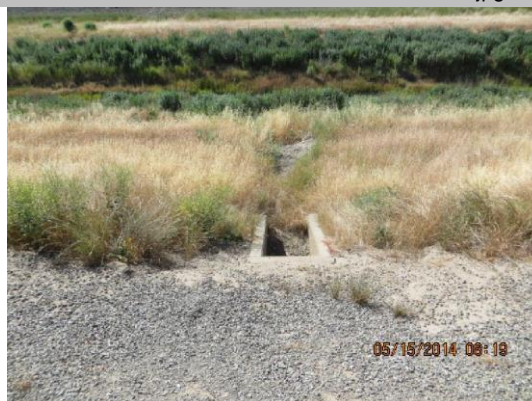
Photo 1 of 3 : UCIP_FA_2020_37841_68843.jpg

LM Start	7.11	Rating **	A/W	Issue No.	1099	
LM End	7.11	Issue Type +	Ma	Location *		
Category	Supplemental			GPS Latitude/Longitude		
				Start		End
Item	DWR UCIP LMA Responsibility			38.064076 °	38.064076 °	
				-121.254656 °	-121.254656 °	
DWR ID	23563					
Comment Code						
Inspector Comment						
DS_ID:23563 FS_ID:37841 EP_NO: N/A Repair Type: No Action Needed EVAL Issue: Crossing Status: Found UCIP Comments: FIELD_STRUCT_DESC: 24-inch corrugated metal storm drainage pipe through the levee, 7 feet below the crown. Concrete U-shaped headwalls on both ends. Flap gate on the waterside (WS) end. Cobble grouted spillway across berm. Cobble grouted apron on the landside (LS) end. [Additional Reference(s): DWR Levee Log, 1987. USACE San Joaquin O&M Manual 612.2, 1967, (HLM 7.51) and 612 (addendum), February 1999, (HLM 7.45) (Station 393+26)]. FS Date: 5/15/2014

Pipe, headwall, flapgate, and grouted spillway on WS toe.

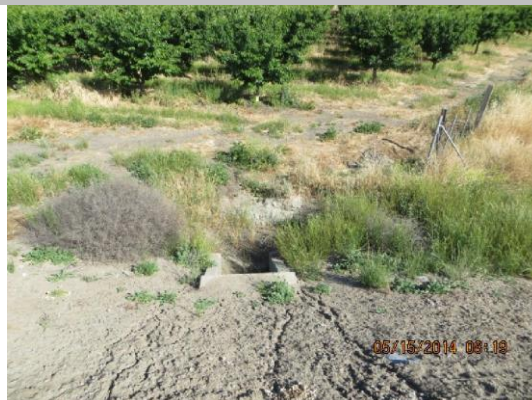
Photo 2 of 3 : UCIP_FA_2020_37841_68842.jpg

Pipe and headwall at LS toe.

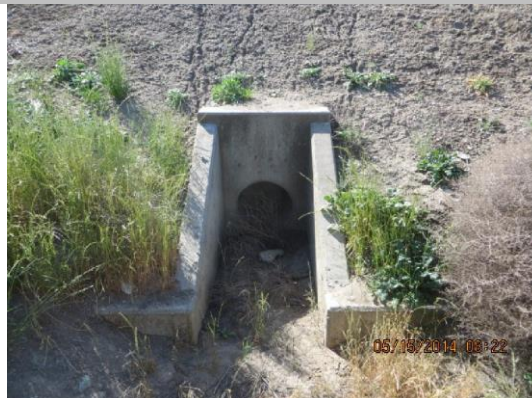
Photo 3 of 3 : UCIP_FA_2020_37841_68841.jpg

Pipe and headwall at LS toe.

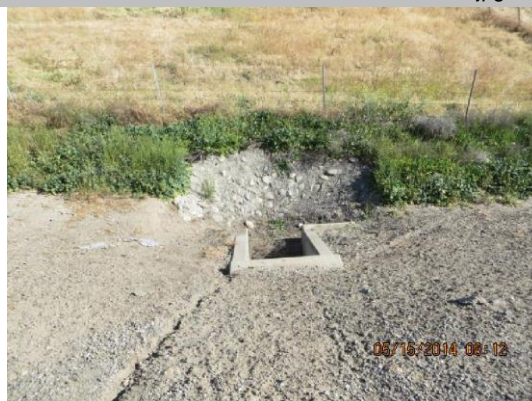
Photo 1 of 3 : UCIP_FA_2020_37840_68838.jpg

DS_ID:23564
 FS_ID:37840
 EP_NO: N/A
 Repair Type: No Action Needed
 EVAL Issue:
 Crossing Status: Found
 UCIP Comments:
 FIELD_STRUCT_DESC: 24-inch corrugated metal drainage pipe through the levee, 7.5 feet below the crown. Concrete U-shaped headwalls on both ends. Flap gate on the waterside (WS) end. Cobble grouted spillway across the berm. Cobble grouted apron on the landside (LS) end. [Additional Reference(s): DWR Levee Log, 1987. USACE San Joaquin O&M Manual 612.2, 1967, (HLM 7.72)].
 FS Date: 5/15/2014

Pipe and headwall on LS toe.

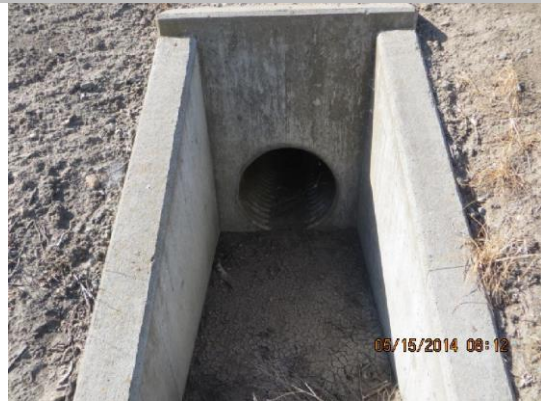
Photo 3 of 3 : UCIP_FA_2020_37840_68836.jpg

Pipe and headwall on LS toe.

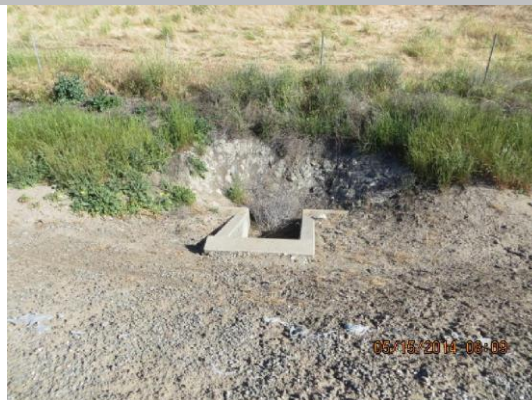
Photo 2 of 3 : UCIP_FA_2020_37839_68832.jpg

Pipe and headwall on LS toe.

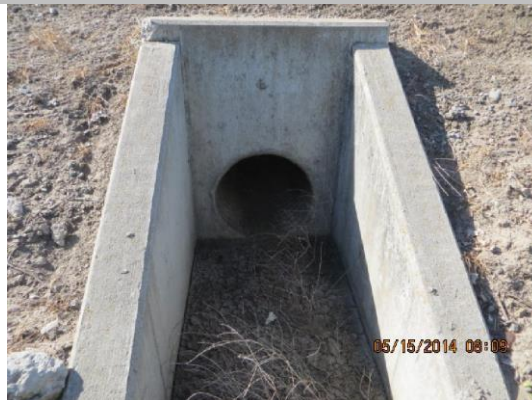
Photo 3 of 3 : UCIP_FA_2020_37839_68831.jpg

Pipe and headwall on LS toe.

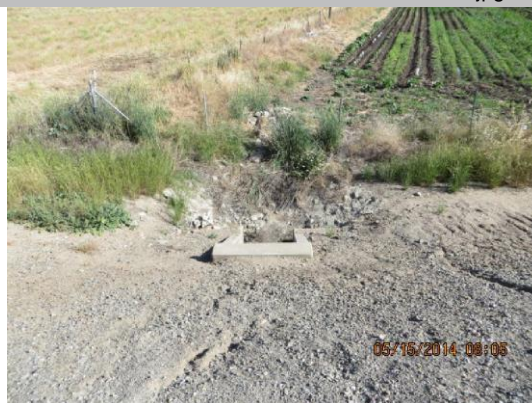
Photo 1 of 3 : UCIP_FA_2020_37838_68828.jpg

DS_ID:23566
 FS_ID:37838
 EP_NO: N/A
 Repair Type: No Action Needed
 EVAL Issue:
 Crossing Status: Found
 UCIP Comments:
 FIELD_STRUCT_DESC: 24-inch corrugated metal storm drainage pipe through the levee, 7 feet below the crown. Concrete U-shaped headwalls on both ends. Flap gate on the waterside (WS) end. Cobble grouted spillway across the berm. Cobble grouted apron on the landside (LS) end. [Additional Reference(s): DWR Levee Log, 1987. USACE San Joaquin O&M Manual 612.2, 1967, (HLM 7.76) and 612 (addendum), February 1999, (HLM 7.78) (Station 410+54)].
 FS Date: 5/15/2014

Pipe and headwall on LS toe.

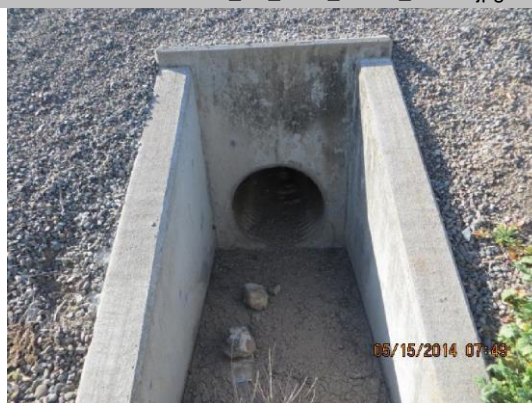
Photo 3 of 3 : UCIP_FA_2020_37837_68821.jpg

Pipe and headwall on LS toe.

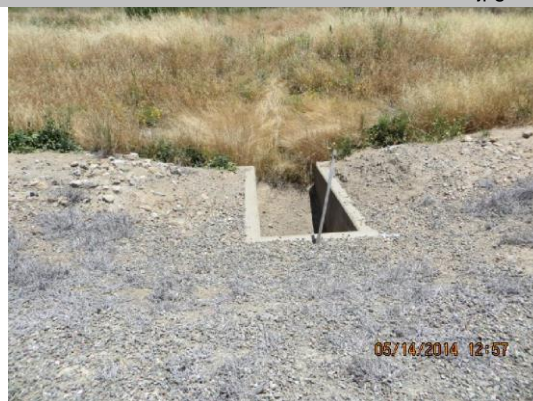
Photo 1 of 3 : UCIP_FA_2020_37835_68818.jpg

LM Start	7.73	Rating **	A/W	Issue No.	1104	
LM End	7.73	Issue Type +	Ma	Location *		
Category	Supplemental			GPS Latitude/Longitude		
				Start	End	
Item	DWR UCIP LMA Responsibility			38.067466 °	38.067466 °	
				-121.244455 °	-121.244455 °	
DWR ID	23568					
Comment Code						
Inspector Comment						
DS_ID:23568						
FS_ID:37835						
EP_NO: N/A						
Repair Type: No Action Needed						
EVAL Issue:						
Crossing Status: Found						
UCIP Comments:						
FIELD_STRUCT_DESC: 36-inch corrugated metal drainage pipe through the levee, 8 feet below the crown. Concrete U-shaped headwalls on both ends. Flap gate on the waterside (WS) end. Cobble grouted spillway across the berm. Cobble grouted apron on the landside (LS) end. [Additional Reference(s): DWR Levee Log, 1987. USACE San Joaquin O&M Manual 612.2, 1967, (HLM 8.15)].						
FS Date: 5/14/2014

Pipe, flapgate, and headwall at WS toe.

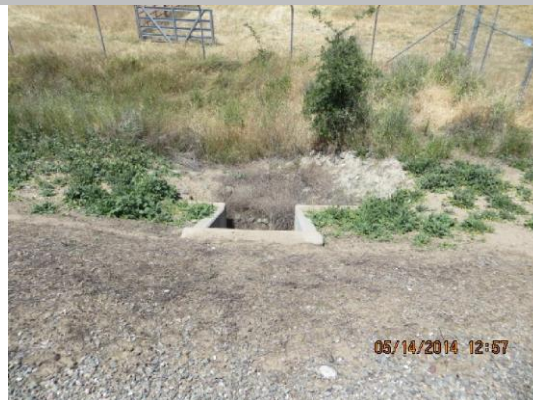
Photo 2 of 3 : UCIP_FA_2020_37835_68817.jpg

Pipe and headwall at LS toe.

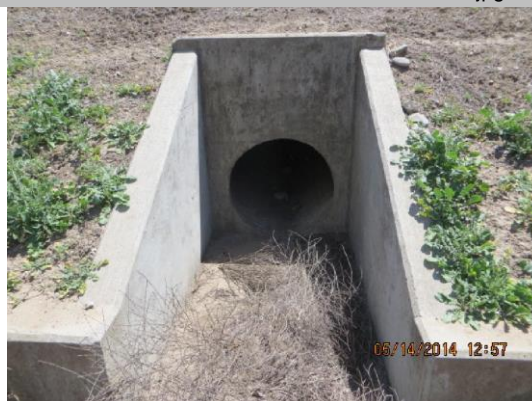
Photo 3 of 3 : UCIP_FA_2020_37835_68816.jpg

Pipe and headwall at LS toe.

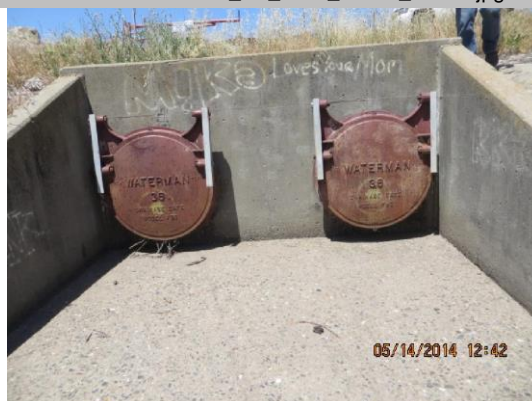
Photo 3 of 3 : UCIP_FA_2020_37832_68811.jpg

Pipe, headwall, and flapgate on WS toe.

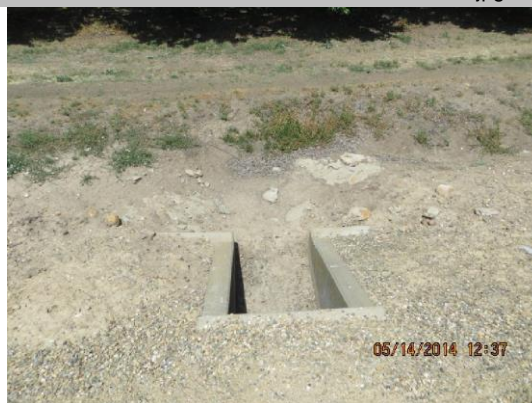
Photo 1 of 3 : UCIP_FA_2020_37830_68804.jpg

DS_ID:23570
 FS_ID:37830
 EP_NO: N/A
 Repair Type: No Action Needed
 EVAL Issue:
 Crossing Status: Found
 UCIP Comments:
 FIELD_STRUCT_DESC: 24-inch corrugated metal storm drainage pipe through the levee, 6.5 feet below the crown. Flap gate on the waterside (WS) end. Concrete U-shaped headwalls on both ends. Cobble grouted spillway across the berm. Cobble grouted apron on the landside (LS) end. [Additional Reference(s): DWR Levee Log, 1987. USACE San Joaquin O&M Manual 612.2, 1967, (HLM 8.49) and 612 (addendum), February 1999, (HLM 8.41) (Station 444+00)].
 FS Date: 5/14/2014

Pipe and headwall on LS toe.

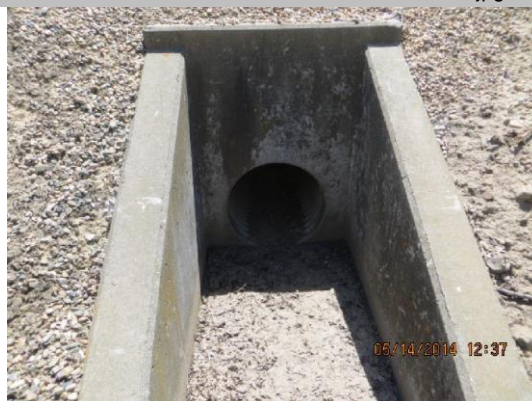
Photo 2 of 3 : UCIP_FA_2020_37830_68803.jpg

Pipe and headwall on LS toe.

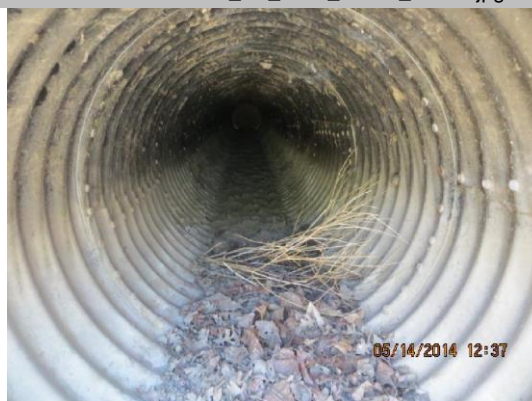
Photo 3 of 3 : UCIP_FA_2020_37830_68802.jpg

Inside pipe on LS toe.

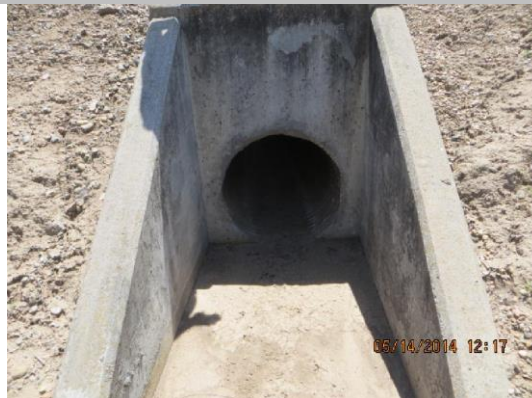
Photo 1 of 3 : UCIP_FA_2020_37826_68796.jpg

Comment Code						
Inspector Comment						
DS_ID:23572 FS_ID:37826 EP_NO: N/A Repair Type: Non-Urgent EVAL Issue: Crossing Status: Found UCIP Comments: A gap at the joint between pipe sections was noted inside pipe at LS toe. This may indicate a need for further maintenance. FIELD_STRUCT_DESC: 36-inch corrugated metal drainage pipe through the levee, 7 feet below the crown. Flap gate on the waterside (WS) end. Concrete U-shaped headwalls on both ends. Cobble grouted spillway across the berm. Cobble grouted apron on the landside (LS) end. [Additional Reference(s): DWR Levee Log, 1987. USACE San Joaquin O&M Manual 612.2, 1967, (HLM 8.77)]. FS Date: 5/14/2014

Pipe and headwall on LS toe.

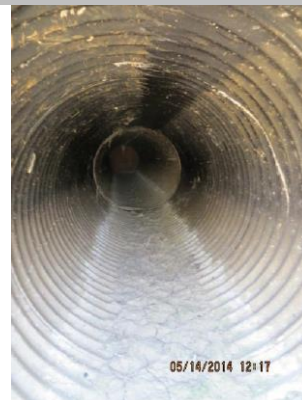
Photo 2 of 3 : UCIP_FA_2020_37826_68795.jpg

Inside pipe at LS toe. Note gap at joint between pipes.

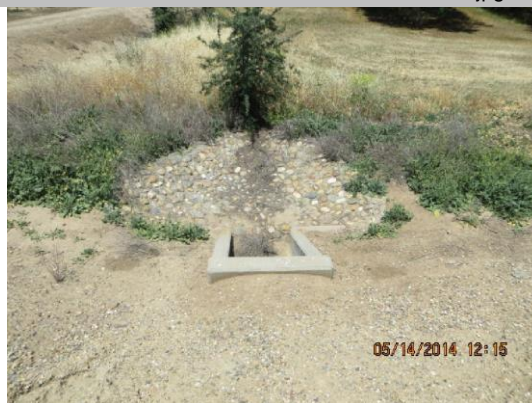
Photo 1 of 3 : UCIP_FA_2020_37825_68791.jpg

DS_ID:23573
 FS_ID:37825
 EP_NO: N/A
 Repair Type: Non-Urgent
 EVAL Issue:
 Crossing Status: Found
 UCIP Comments: Some gaps in Joints between pipe sections noted inside pipe on LS toe. May indicate a need for further maintenance.
 FIELD_STRUCT_DESC: 24-inch corrugated metal drainage pipe through the levee, 6.5 feet below the crown. Flap gate on the waterside (WS) end. Concrete U-shaped headwalls on both ends. Cobble grouted spillway across the berm. Cobble grouted apron on the landside (LS) end. [Additional Reference(s): DWR Levee Log, 1987. USACE San Joaquin O&M Manual 612.2, 1967, (HLM 8.78)].
 FS Date: 5/14/2014

Pipe and headwall on LS toe.

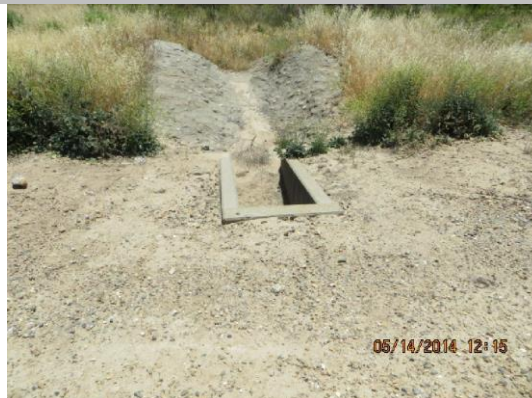
Photo 2 of 3 : UCIP_FA_2020_37825_68790.jpg

Pipe, headwall, flapgate, and grouted spillway on WS toe.

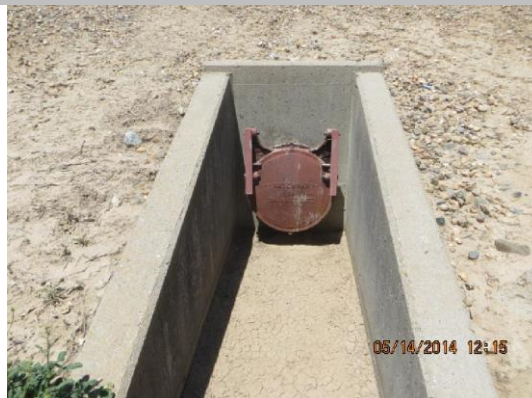
Photo 3 of 3 : UCIP_FA_2020_37825_68789.jpg

Pipe, headwall, and flapgate on WS toe.

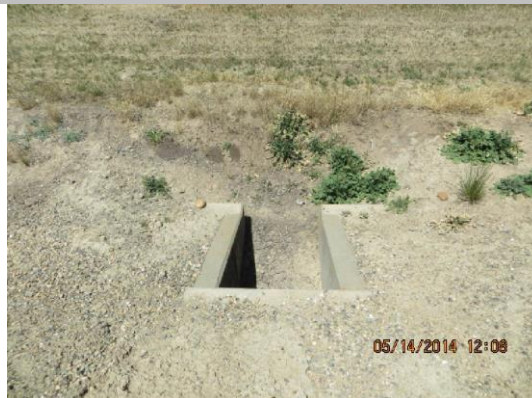
Photo 1 of 3 : UCIP_FA_2020_37818_68761.jpg

Pipe and headwall on LS toe.

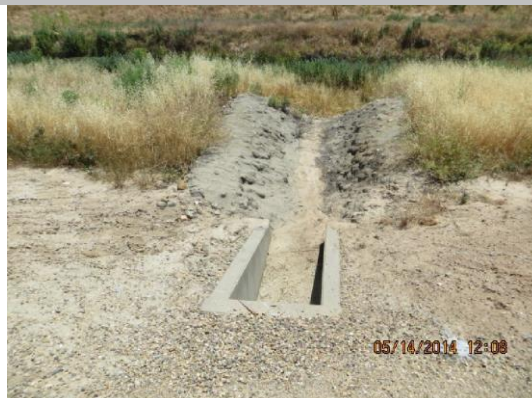
Photo 2 of 3 : UCIP_FA_2020_37818_68760.jpg

Pipe, flapgate, headwall, and grouted spillway on WS toe.

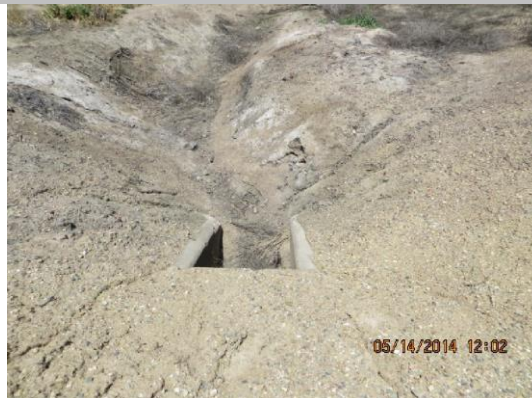
Photo 1 of 3 : UCIP_FA_2020_40206_68756.jpg

Comment Code						
Inspector Comment						
DS_ID:23576						
FS_ID:40206						
EP_NO: N/A						
Repair Type: No Action Needed						
EVAL Issue:						
Crossing Status: Found						
UCIP Comments: Skunks in pipe.						
FIELD_STRUCT_DESC: 24-inch corrugated metal storm drainage pipe through the levee, 6.5 feet below the crown. Flap gate on the waterside (WS) end. Concrete U-shaped headwalls on both ends. Cobble grouted spillway across the berm. Cobble grouted apron on the landside (LS) end. [Additional Reference(s): DWR Levee Log, 1987. USACE San Joaquin O&M Manual 612.2, 1967, (HLM 9.17) and 612 (addendum), February 1999, (HLM 9.17) (Station 484+30)].						
FS Date: 5/14/2014

Pipe and headwall on LS toe.

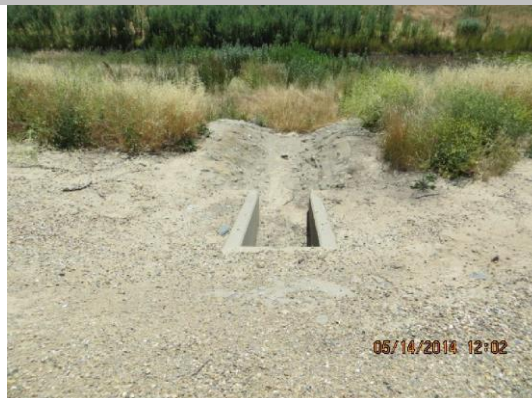
Photo 2 of 3 : UCIP_FA_2020_40206_68755.jpg

Pipe, flapgate, and headwall on WS toe.

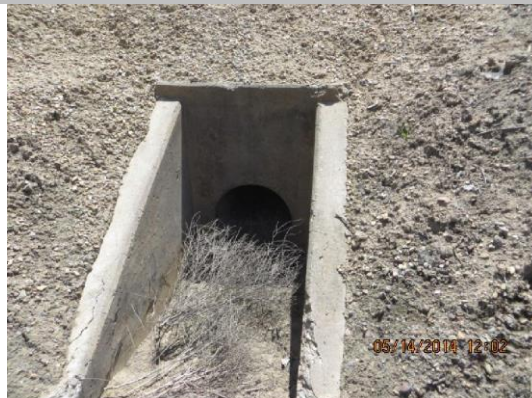
Photo 3 of 3 : UCIP_FA_2020_40206_68754.jpg

Pipe and headwall on LS toe.

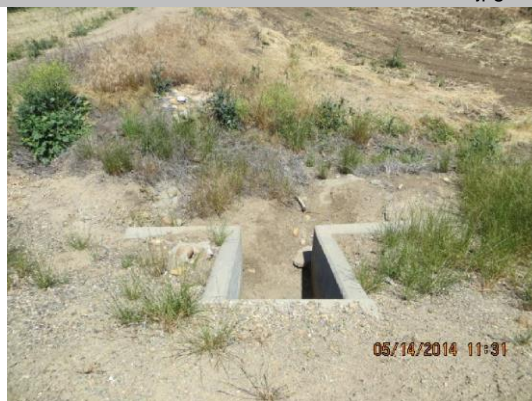
Photo 1 of 3 : UCIP_FA_2020_42951_68751.jpg

Pipe and headwall on LS toe.

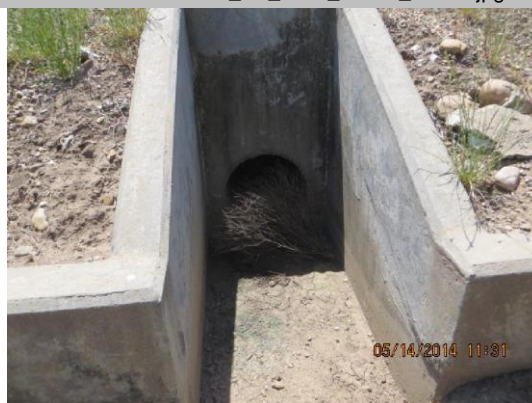
Photo 3 of 3 : UCIP_FA_2020_42951_68749.jpg

Pipe and headwall on LS toe.

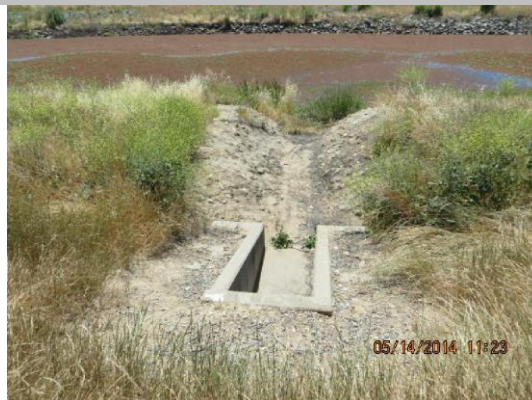
Photo 2 of 3 : UCIP_FA_2020_37813_68746.jpg

Headwall, pipe, flapgate, and grouted spillway on WS toe.

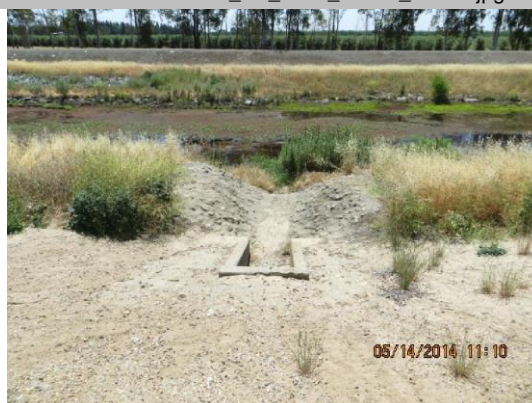
Photo 1 of 3 : UCIP_FA_2020_37810_68742.jpg

Headwall and flapgate on WS toe.

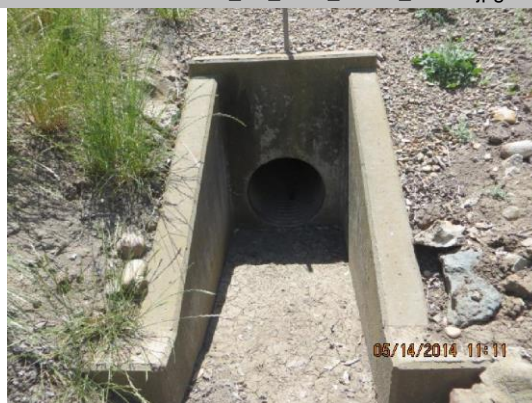
Photo 3 of 3 : UCIP_FA_2020_37810_68740.jpg

Pipe and headwall on LS toe.

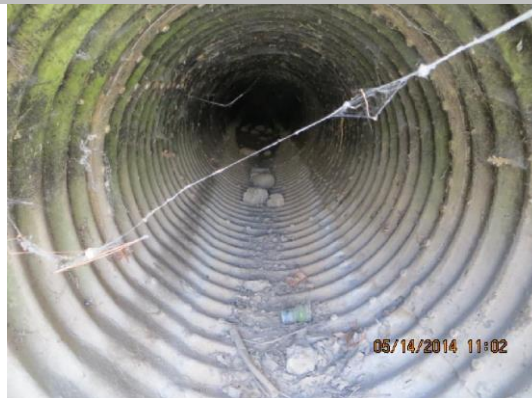
Photo 3 of 3 : UCIP_FA_2020_37809_68736.jpg

Inside pipe at LS toe.

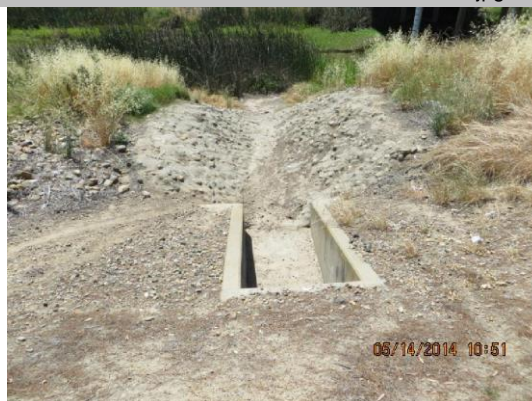
Photo 1 of 3 : UCIP_FA_2020_37807_68732.jpg

Headwall, pipe, flapgate, and grouted spillway on WS toe.

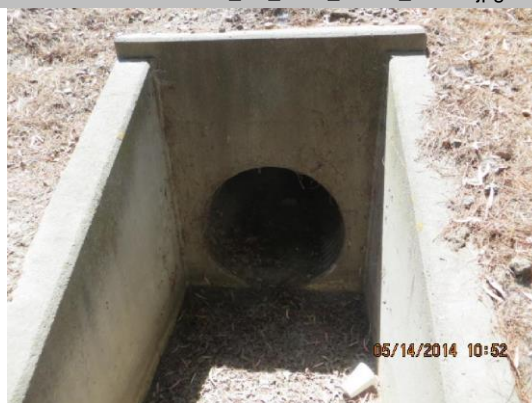
Photo 3 of 3 : UCIP_FA_2020_37807_68730.jpg

Pipe and headwall on LS toe.

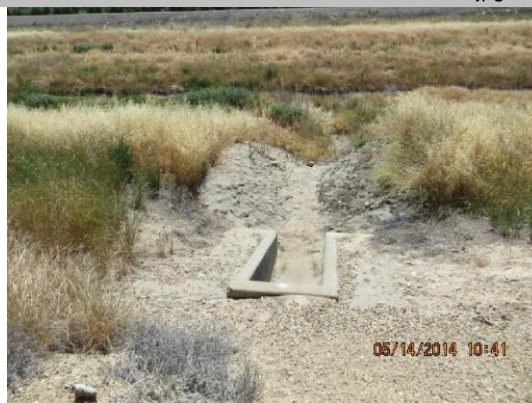
Photo 1 of 3 : UCIP_FA_2020_41804_68727.jpg

Comment Code						
Inspector Comment						
DS_ID:23585						
FS_ID:41804						
EP_NO: N/A						
Repair Type: Non-Urgent						
EVAL Issue:						
Crossing Status: Found						
UCIP Comments: Some silt buildup in pipe.						
FIELD_STRUCT_DESC: 24-inch corrugated metal storm drainage pipe through the levee, 7.5 feet below the crown. Flap gate on the waterside (WS) end. Concrete U-shaped headwalls on both ends. Cobble grouted spillway across the berm. [Additional Reference(s): DWR Levee Log, 1987. USACE San Joaquin O&M Manual 612.2, 1967, (HLM 10.45) and 612 (addendum), February 1999, (HLM 10.46) (Station 552+25)].						
FS Date: 5/14/2014

Headwall, pipe, flapgate, and grouted spillway on WS toe.

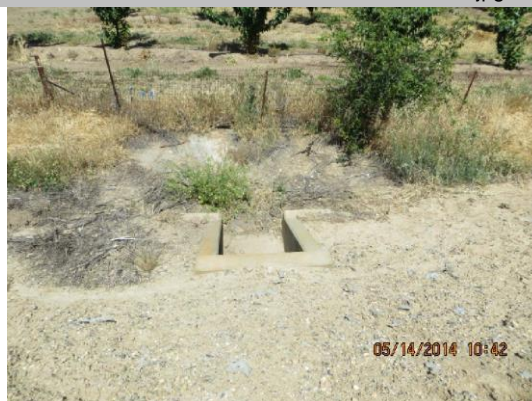
Photo 2 of 3 : UCIP_FA_2020_41804_68726.jpg

Pipe and headwall on LS toe.

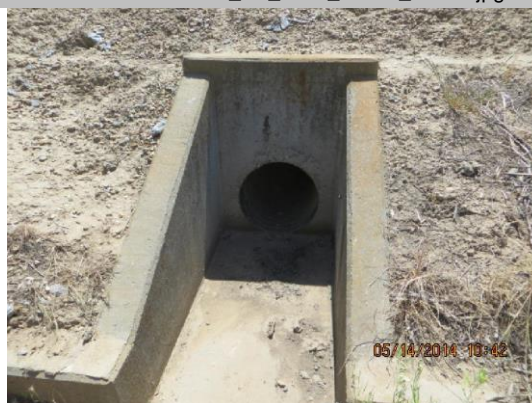
Photo 3 of 3 : UCIP_FA_2020_41804_68725.jpg

Pipe and headwall on LS toe.

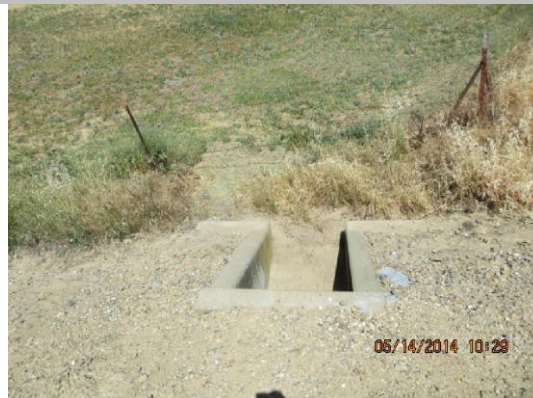
Photo 1 of 3 : UCIP_FA_2020_37803_68722.jpg

Pipe and headwall on LS toe.

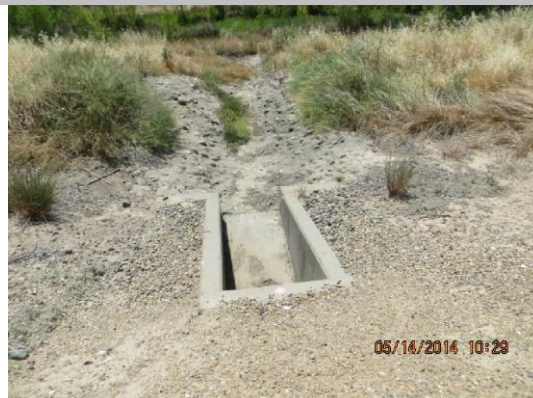
Photo 2 of 3 : UCIP_FA_2020_37803_68721.jpg

Headwall, pipe, flapgate, and grouted spillway on WS toe.

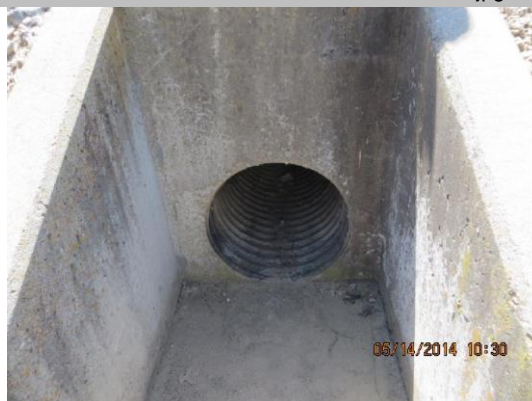
Photo 3 of 3 : UCIP_FA_2020_37803_68720.jpg

Pipe and headwall on LS toe.

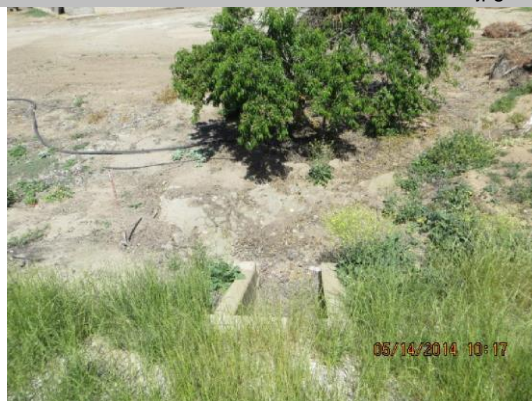
Photo 2 of 3 : UCIP_FA_2020_37786_68700.jpg

Pipe and headwall on LS toe.

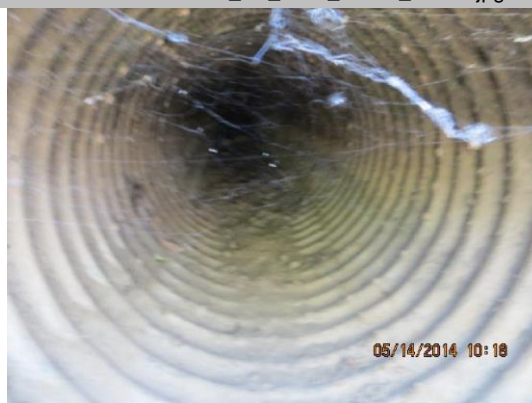
Photo 3 of 3 : UCIP_FA_2020_37786_68703.jpg

Inside pipe from LS toe.

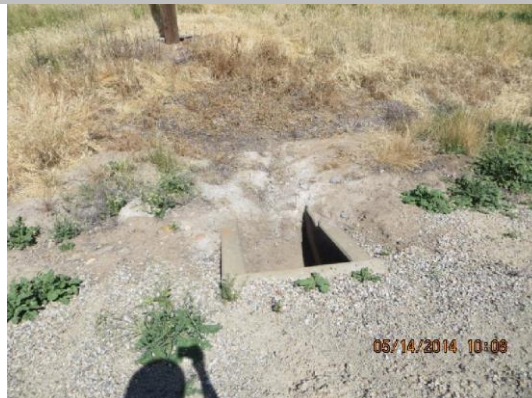
Photo 1 of 3 : UCIP_FA_2020_41805_68682.jpg

Pipe and headwall on LS toe.

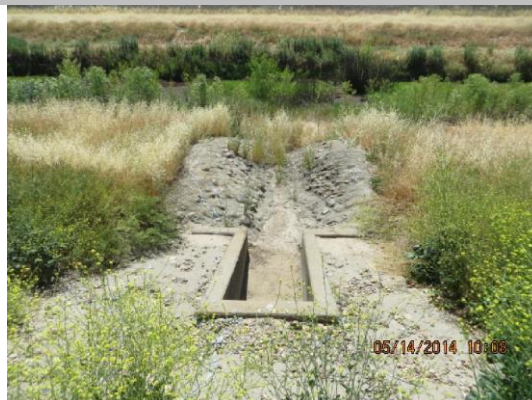
Photo 2 of 3 : UCIP_FA_2020_41805_68681.jpg

Pipe, flapgate, headwall, and grouted spillway on WS toe.

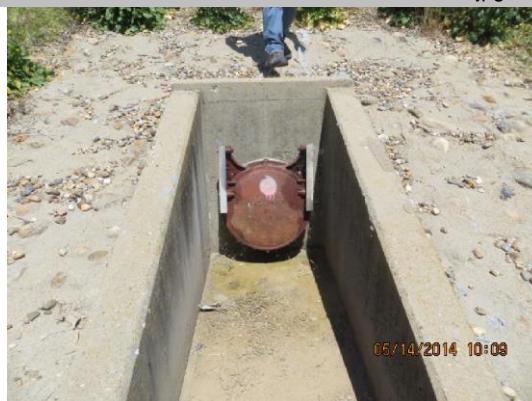
Photo 3 of 3 : UCIP_FA_2020_41805_68680.jpg

Pipe, flapgate, and headwall on WS toe.

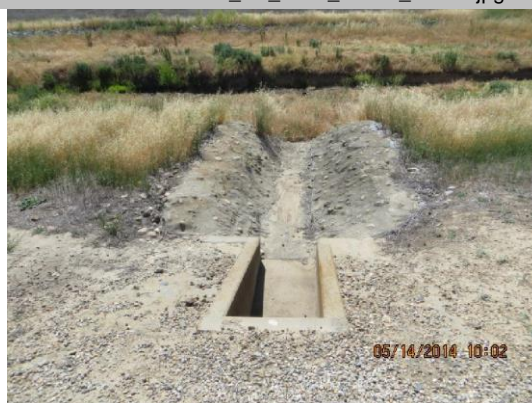
Photo 1 of 3 : UCIP_FA_2020_37779_68666.jpg

Headwall, pipe, flapgate, and grouted spillway on WS slope.

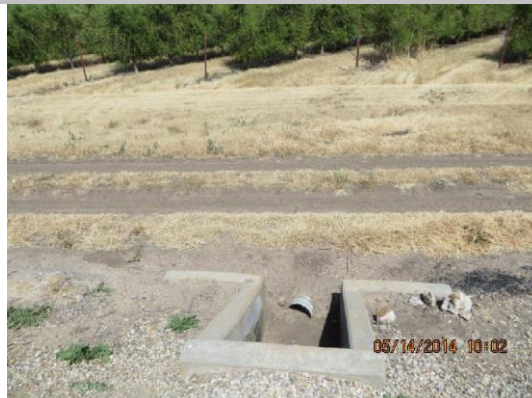
Photo 2 of 3 : UCIP_FA_2020_37779_68665.jpg

Pipe and headwall on LS toe.

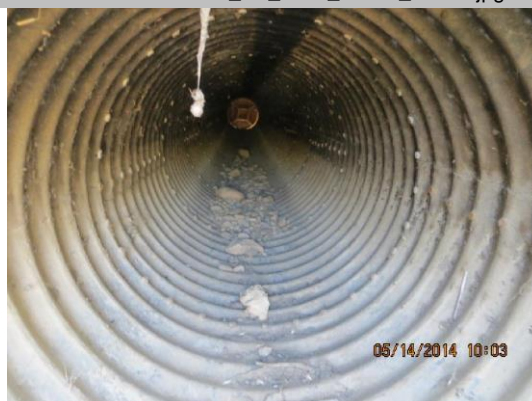
Photo 3 of 3 : UCIP_FA_2020_37779_68659.jpg

Inside pipe at LS toe.

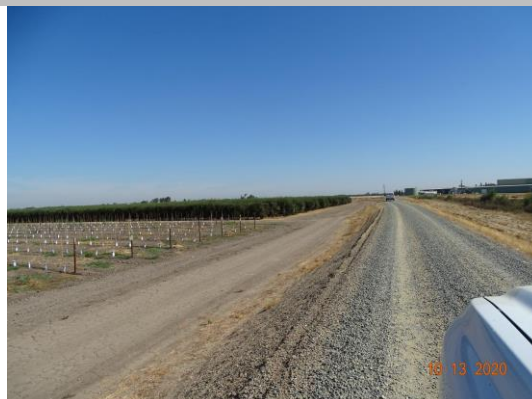
Photo 1 of 1 : FA_2020_NA0017_151_177_20201019_00343.jpg

LM Start	11.06	Rating **	M	Issue No.	177
LM End	11.12	Issue Type +	Ma	Location *	LS
Category	Earthen Levee			GPS Latitude/Longitude	
				Start	End
Item	Slope Stability			38.086323 °	38.086517 °
				-121.192947 °	-121.191732 °
DWR ID	DWR_NA0017_07_f_2020_177				
Comment Code					
S3 : Repair the levee slope damaged by vehicle traffic and prevent access where possible.					
Inspector Comment					
Tire ruts are on the landside slope.

View of tire ruts along the landside shoulder. Fall 2020

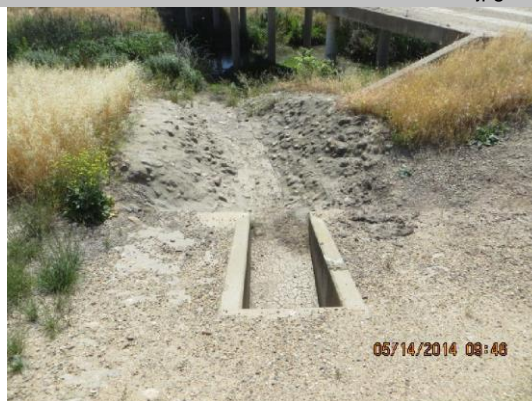
Photo 1 of 3 : UCIP_FA_2020_37773_68635.jpg

Headwall, pipe, flapgate, and grouted spillway on WS slope.

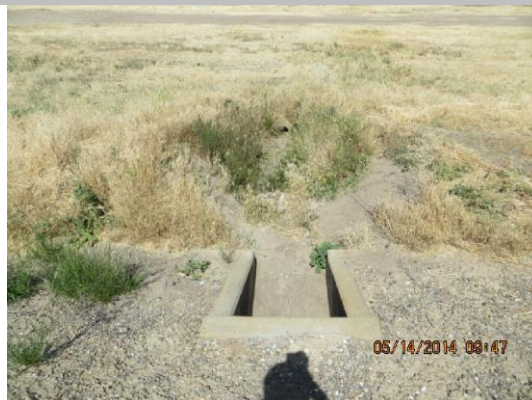
Photo 2 of 3 : UCIP_FA_2020_37773_68634.jpg

Pipe and headwall on LS toe.

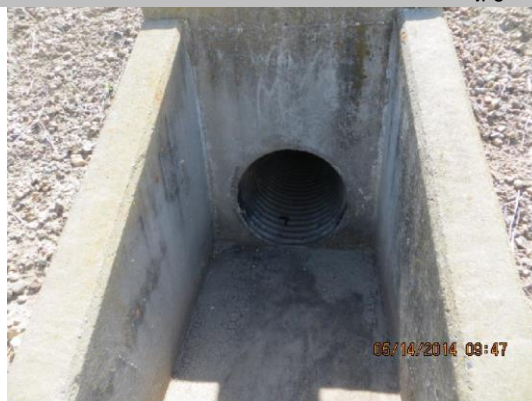
Photo 3 of 3 : UCIP_FA_2020_37773_68633.jpg

Pipe and headwall on LS toe.

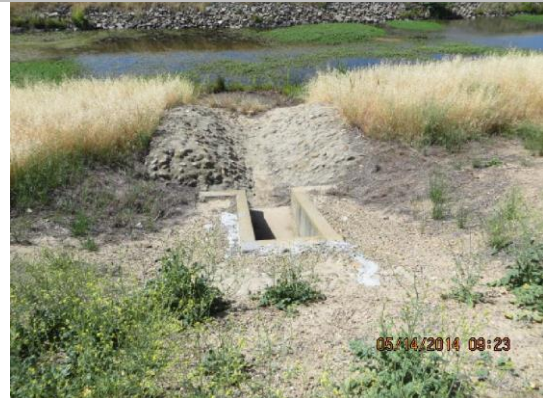
Photo 2 of 3 : UCIP_FA_2020_37753_68593.jpg

Pipe, flapgate, headwall, and grouted spillway on WS toe.

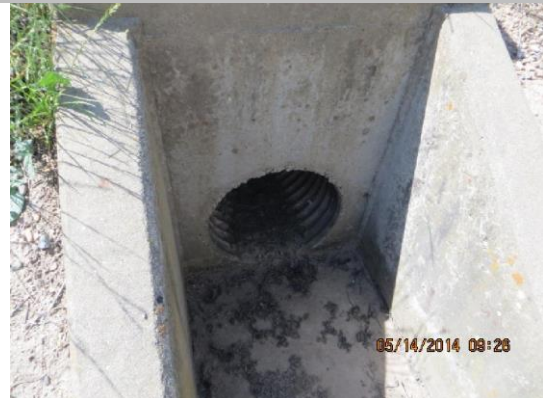
Photo 3 of 3 : UCIP_FA_2020_37753_68592.jpg

Pipe and headwall on LS toe.

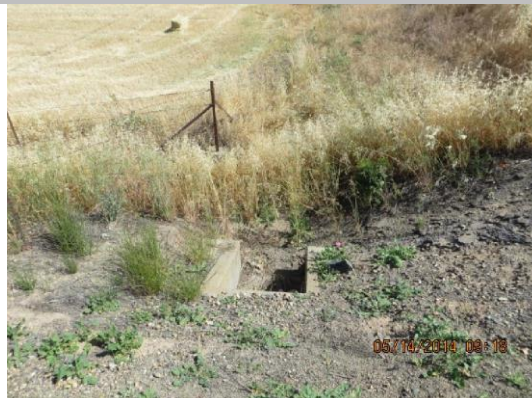
Photo 1 of 3 : UCIP_FA_2020_53044_68589.jpg

Pipe and headwall at the LS toe.

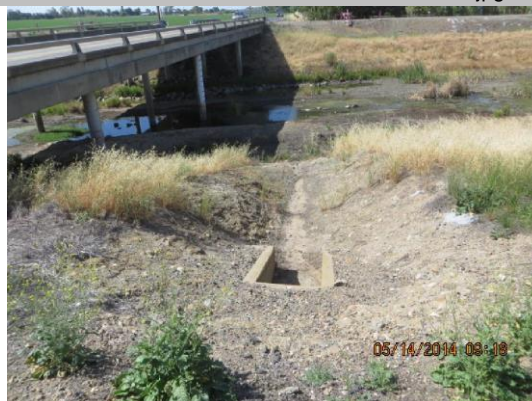
Photo 2 of 3 : UCIP_FA_2020_53044_68588.jpg

Pipe, flap gate, and headwall at the WS toe.

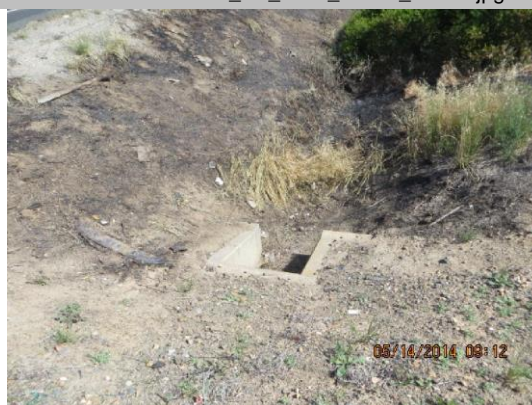
Photo 1 of 3 : UCIP_FA_2020_37751_68585.jpg

Headwall and pipe on LS toe.

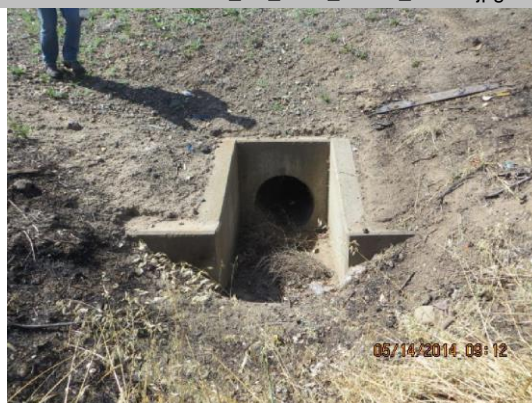
Photo 3 of 3 : UCIP_FA_2020_37751_68583.jpg

Headwall and pipe on LS toe.

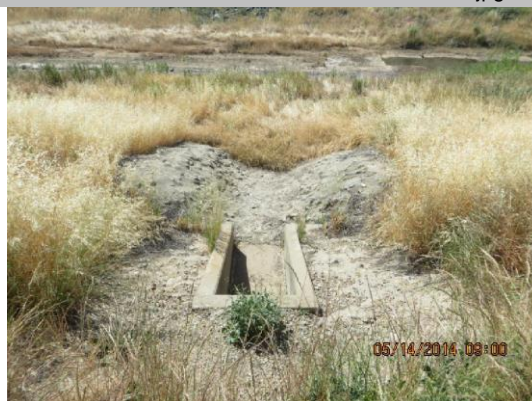
Photo 1 of 3 : UCIP_FA_2020_37745_68567.jpg

Pipe, flapgate, headwall, and grouted spillway on WS toe.

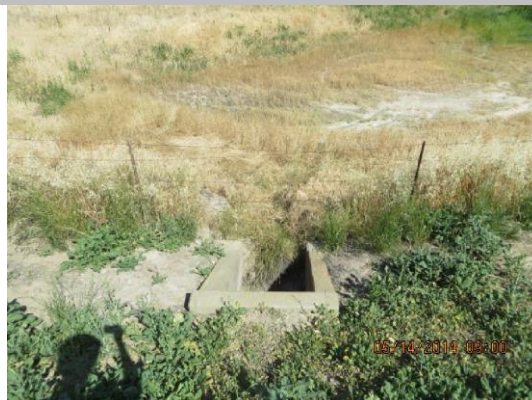
Photo 2 of 3 : UCIP_FA_2020_37745_68566.jpg

Pipe and headwall on LS toe.

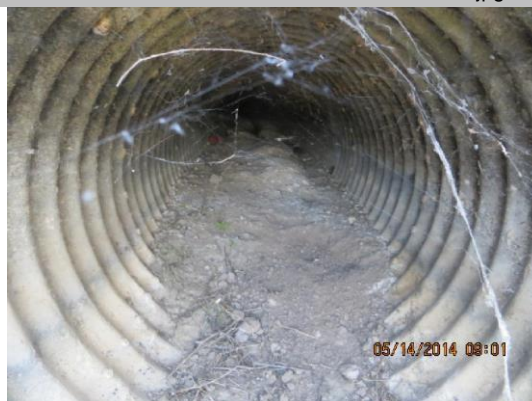
Photo 3 of 3 : UCIP_FA_2020_37745_68565.jpg

Inside of pipe on LS toe. Silt buildup.

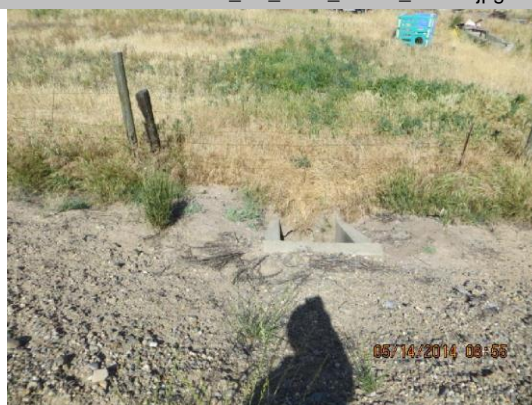
Photo 1 of 3 : UCIP_FA_2020_37732_68555.jpg

Pipe and headwall at LS toe.

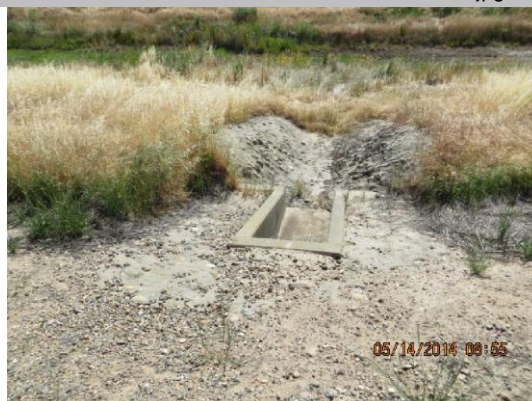
Photo 2 of 3 : UCIP_FA_2020_37732_68554.jpg

Pipe, flapgate, headwall, and grouted spillway on WS toe.

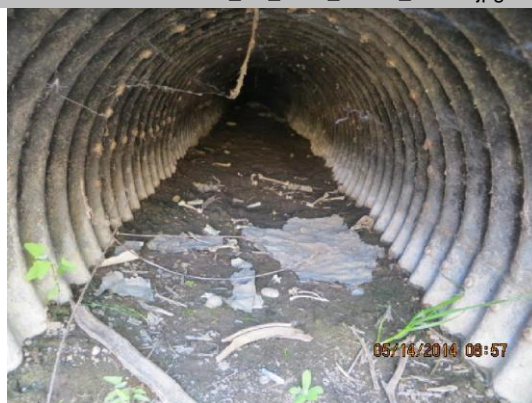
Photo 3 of 3 : UCIP_FA_2020_37732_68553.jpg

Inside pipe at LS toe.

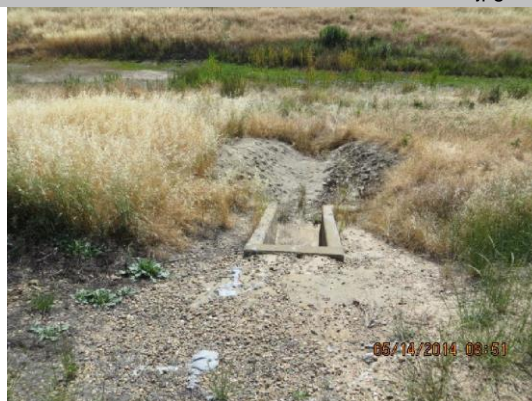
Photo 1 of 3 : UCIP_FA_2020_37731_68550.jpg

Pipe, flapgate, and headwall on WS toe.

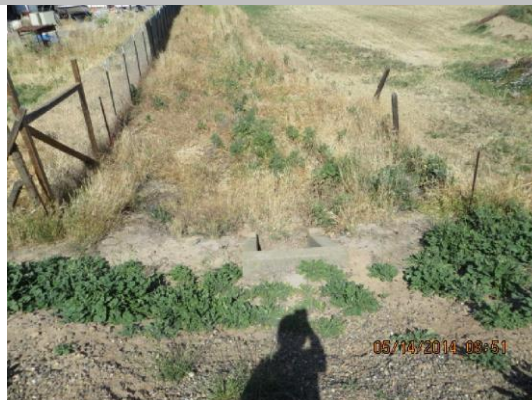
Photo 2 of 3 : UCIP_FA_2020_37731_68549.jpg

Pipe and headwall on LS toe.

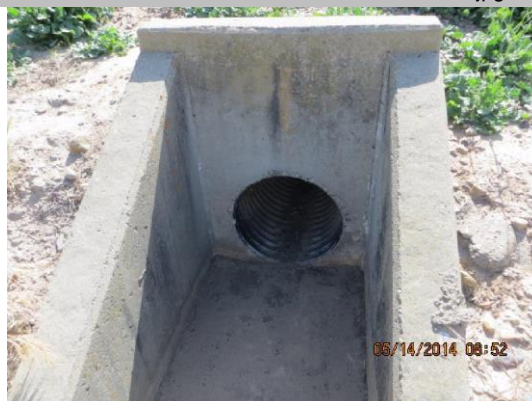
Photo 3 of 3 : UCIP_FA_2020_37731_68548.jpg

Pipe and headwall on LS toe.

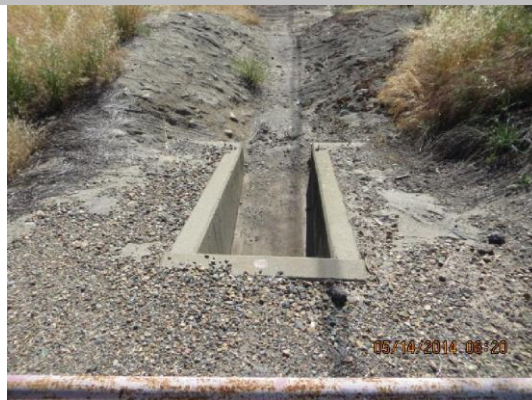
Photo 2 of 3 : UCIP_FA_2020_37719_68527.jpg

Pipe, flapgate, and headwall on WS toe.

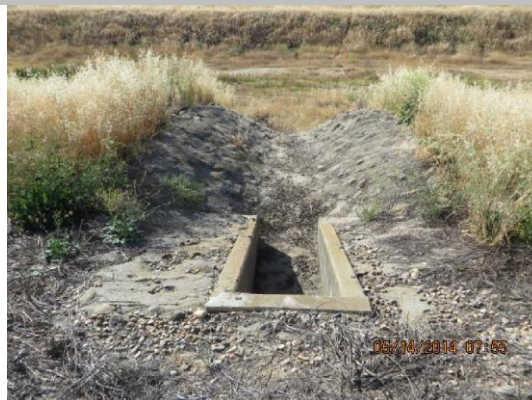
Photo 2 of 3 : UCIP_FA_2020_37690_68449.jpg

Pipe, flapgate, headwall, and grouted spillway on WS slope.

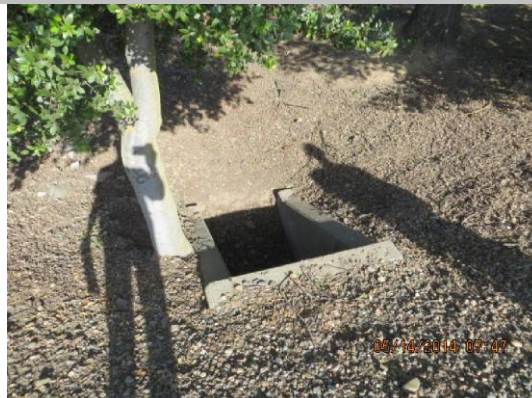
Photo 1 of 3 : UCIP_FA_2020_37689_68446.jpg

Pipe and concrete headwall on LS slope.

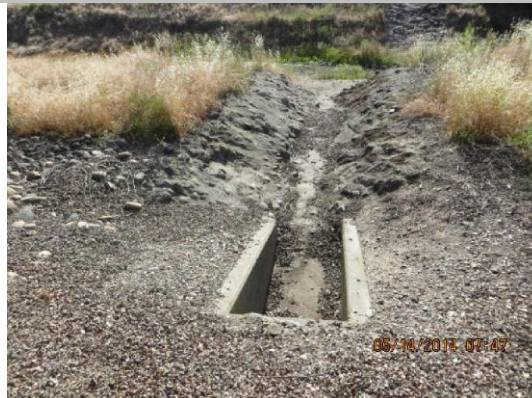
Photo 2 of 3 : UCIP_FA_2020_37689_68445.jpg

Pipe, flapgate, headwall, and grouted spillway on WS slope.

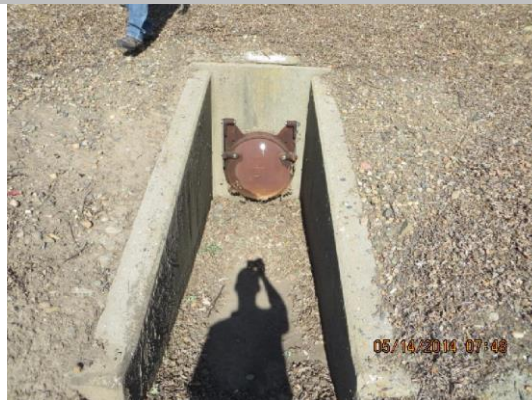
Photo 3 of 3 : UCIP_FA_2020_37689_68444.jpg

Pipe, flapgate, headwall, and grouted spillway on WS slope.

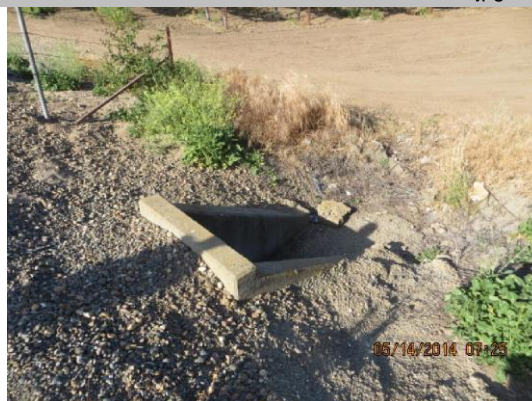
Photo 1 of 3 : UCIP_FA_2020_37675_68408.jpg

Pipe and concrete headwall on LS toe.

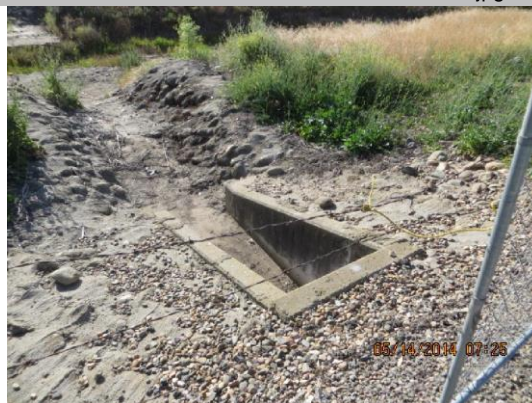
Photo 2 of 3 : UCIP_FA_2020_37675_68405.jpg

Pipe, flapgate, grouted spillway, and concrete headwall on WS toe.

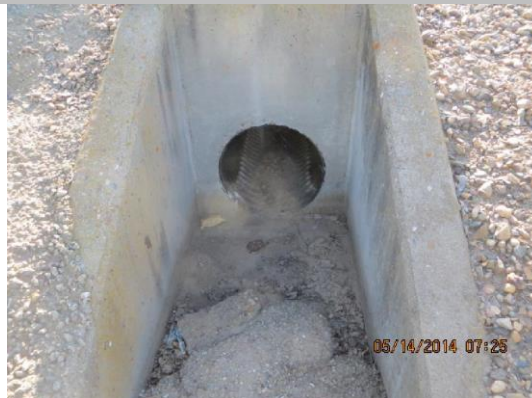
Photo 3 of 3 : UCIP_FA_2020_37675_68402.jpg

Pipe and concrete headwall on LS toe.

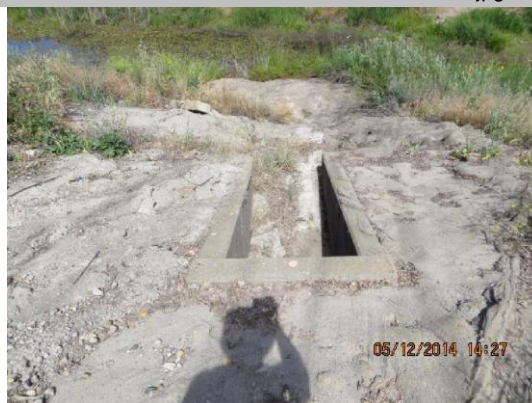
Photo 1 of 3 : UCIP_FA_2020_37666_68385.jpg

DS_ID:23601
 FS_ID:37666
 EP_NO: N/A
 Repair Type: No Action Needed
 EVAL Issue:
 Crossing Status: Found
 UCIP Comments:
 FIELD_STRUCT_DESC: 24-inch corrugated metal drainage pipe through the levee, 8 feet below the crown. Concrete U-shaped headwall on the waterside (WS) end. Flap gate on the WS end. Cobble grouted spillway. 24-inch corrugated metal drop inlet and cobble grouted intake on the landside (LS), no headwall. (Drainage ditch and 12-inch culverts adjacent to levee installed under Permit No. 12659, 1979 - Richard Stasand). [Additional Reference(s): DWR Levee Log, 1987. USACE San Joaquin O&M Manual 612.2, 1967, (HLM 14.39)].
 FS Date: 5/12/2014

Pipe, flapgate, and headwall on WS slope.

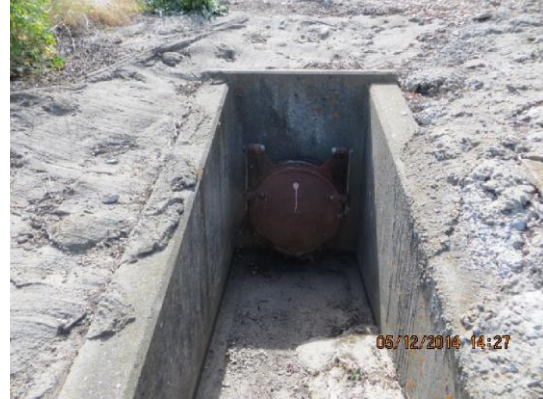
Photo 2 of 3 : UCIP_FA_2020_37666_68384.jpg

Pipe, flapgate, and headwall on WS slope.

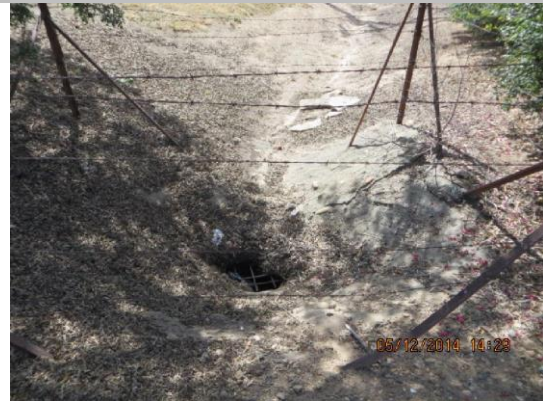
Photo 3 of 3 : UCIP_FA_2020_37666_68383.jpg

Drop-inlet on LS toe.

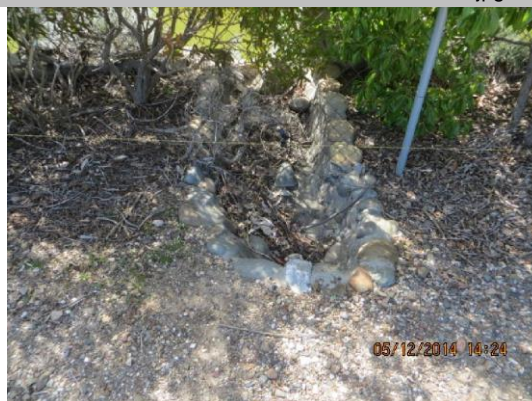
Photo 1 of 3 : UCIP_FA_2020_37663_68359.jpg

Cobble grouted inlet from fish pond on LS toe.

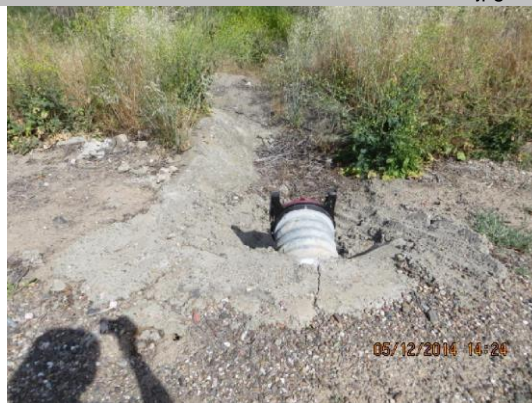
Photo 2 of 3 : UCIP_FA_2020_37663_68358.jpg

Pipe, flapgate, and grouted spillway on WS slope.

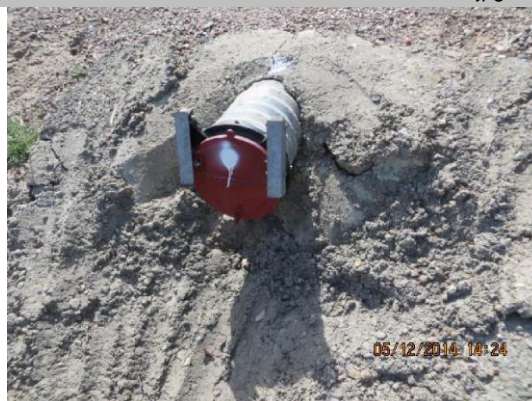
Photo 3 of 3 : UCIP_FA_2020_37663_68357.jpg

Pipe, flapgate, and grouted spillway on WS slope.

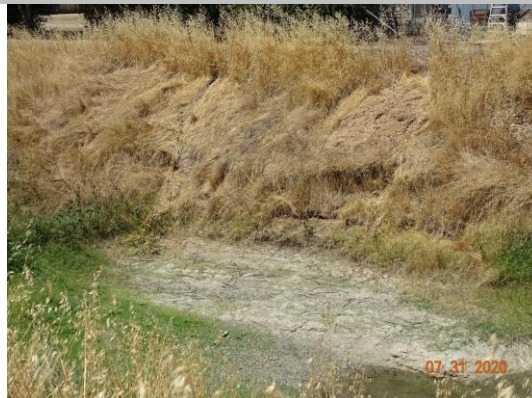
Photo 2 of 2 : SJR2019_DWR_NA0017_07_f_2018_148_07.JPG

7/31/2020: View of the 20-ft long erosion pocket on the downstream end.

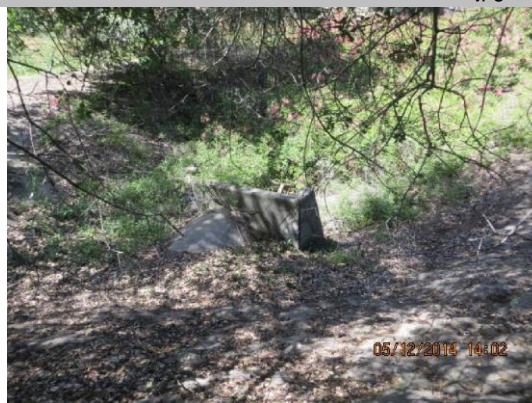
Photo 1 of 3 : UCIP_FA_2020_37660_68354.jpg

Pipe and headwall on LS toe.

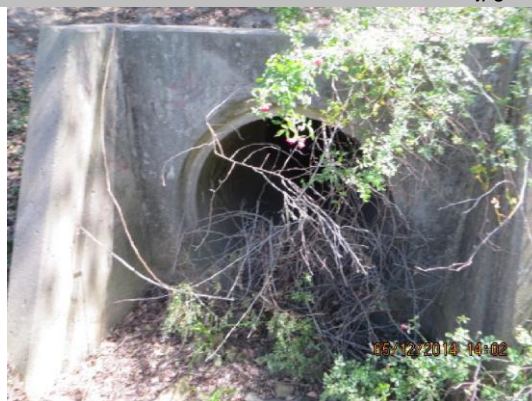
Photo 2 of 3 : UCIP_FA_2020_37660_68353.jpg

Pipe and headwall on LS toe.

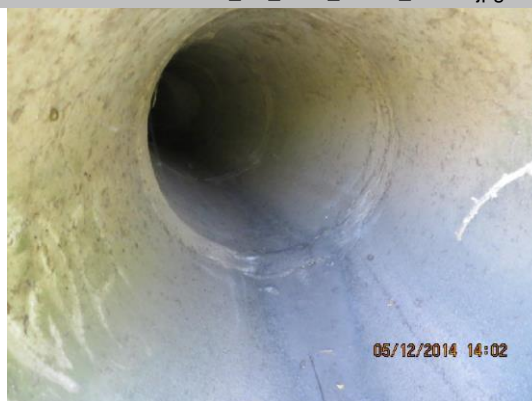
Photo 3 of 3 : UCIP_FA_2020_37660_68352.jpg

Inside concrete pipe at LS toe.

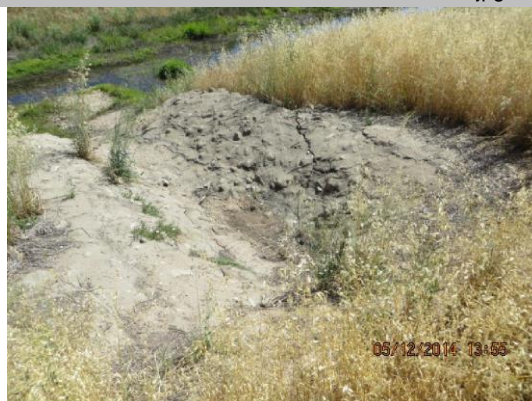
Photo 1 of 3 : UCIP_FA_2020_37658_68343.jpg

Grouted spillway and pipe visible on WS slope.

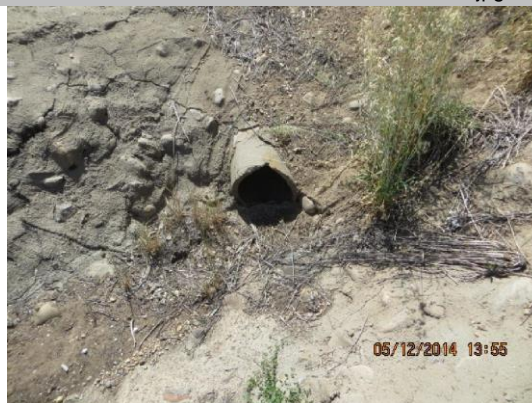
Photo 2 of 3 : UCIP_FA_2020_37658_68342.jpg

Grouted spillway and pipe visible on WS slope.

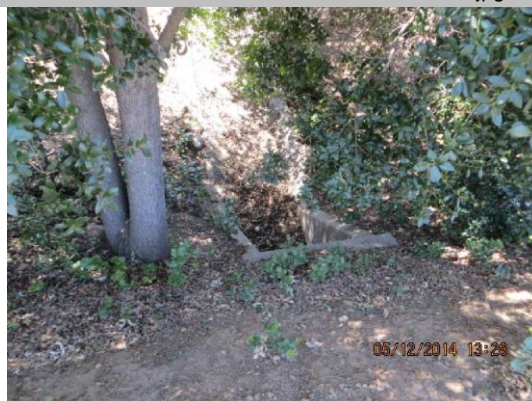
Photo 2 of 3 : UCIP_FA_2020_37655_68335.jpg

Concrete headwall and pipe at LS toe.
