**Flood Control Project Maintenance
Levee Inspections**

Maintenance Issue Types Only, Levee Inspection Report By Mile - Fall 2020

San Joaquin County Flood Control and Water Conservation District

Waterway	Bank	Unit Miles	Inspection Start/End	Inspector
Unit No. 01 Littlejohn Creek	Left	2.59	10/20/2020 10/20/2020	Alberto De Leon

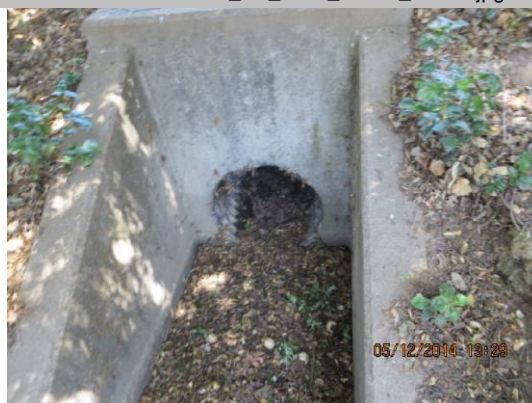
Photo 3 of 3 : UCIP_FA_2020_37655_68334.jpg

Concrete headwall and pipe at LS toe.

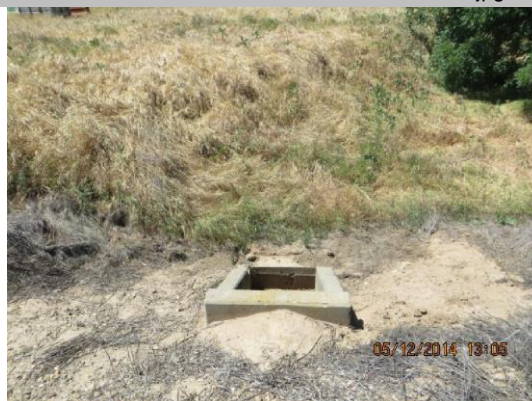
Photo 1 of 3 : UCIP_FA_2020_37653_68329.jpg

Concrete headwall on LS toe.

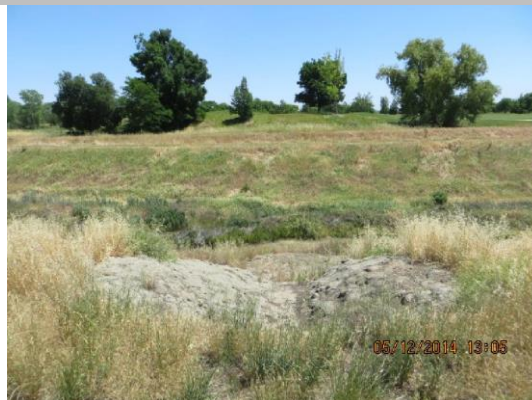
Photo 2 of 3 : UCIP_FA_2020_37653_68328.jpg

Grouted spillway on WS slope.

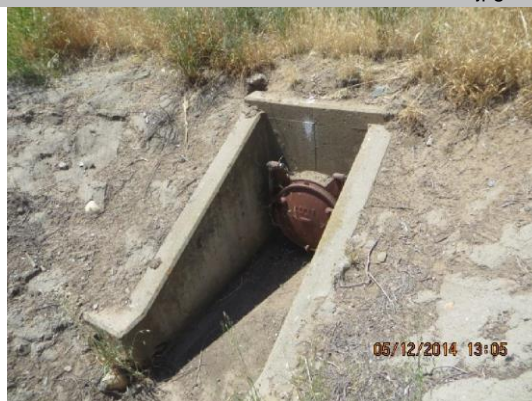
Photo 3 of 3 : UCIP_FA_2020_37653_68327.jpg

Pipe, flapgate, headwall, and grouted spillway on WS slope.

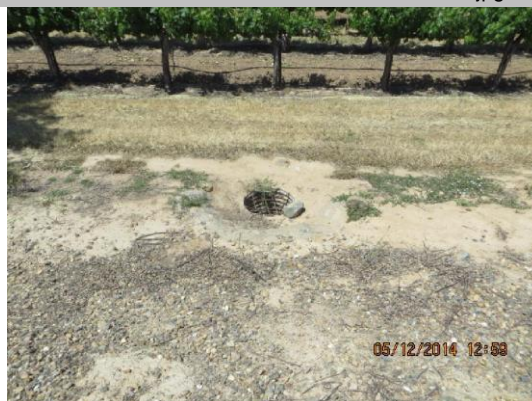
Photo 1 of 3 : UCIP_FA_2020_37652_68326.jpg

24-inch riser/dropinlet on LS toe.

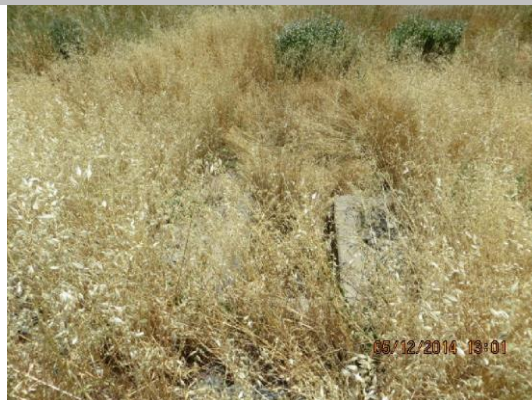
Photo 2 of 3 : UCIP_FA_2020_37652_68325.jpg

Concrete headwall on WS toe.

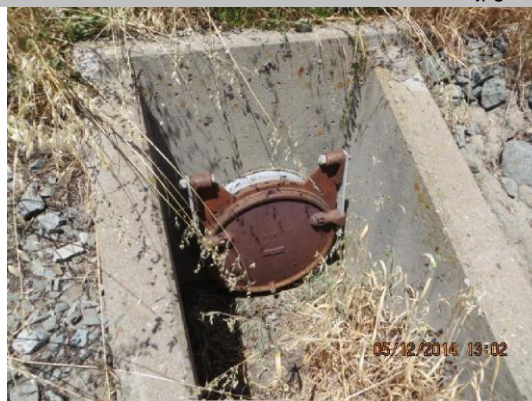
Photo 3 of 3 : UCIP_FA_2020_37652_68324.jpg

Pipe, flapgate, and Concrete headwall on WS slope.

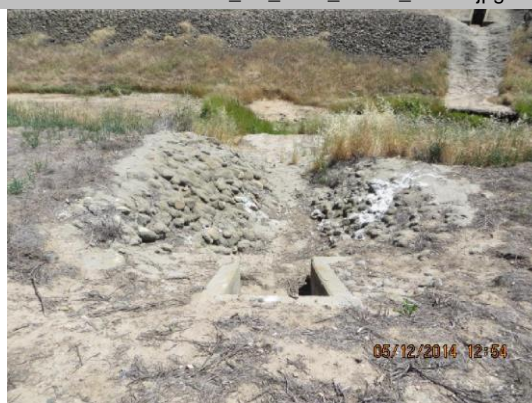
Photo 1 of 3 : UCIP_FA_2020_37651_68322.jpg

DS_ID:23611
 FS_ID:37651
 EP_NO: N/A
 Repair Type: No Action Needed
 EVAL Issue:
 Crossing Status: Found
 UCIP Comments:
 FIELD_STRUCT_DESC: 24-inch corrugated metal drainage pipe through the levee, 4 feet below the crown. Concrete U-shaped headwall on both ends. Flap gate on the waterside (WS) end. Cobble grouted spillway. Cobble grouted intake on the landside (LS). [Additional Reference(s): DWR Levee Log, 1987. USACE San Joaquin O&M Manual 612.2, 1967, (HLM 15.90)].
 FS Date: 5/12/2014

Concrete headwall and grouted spillway on WS slope.

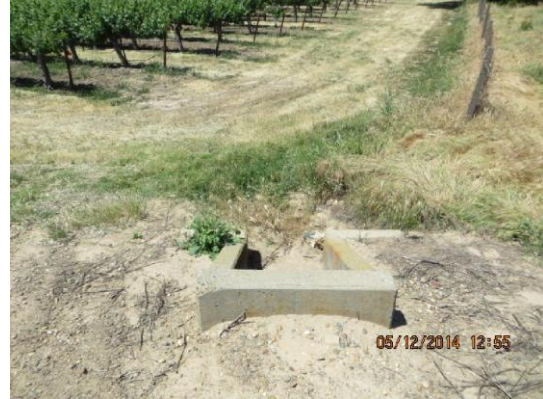
Photo 2 of 3 : UCIP_FA_2020_37651_68321.jpg

concrete headwall on LS toe.

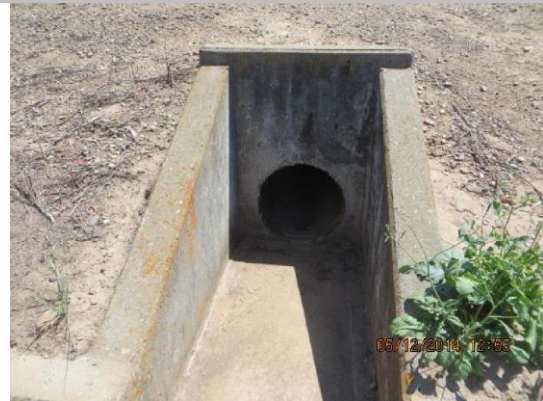
Photo 3 of 3 : UCIP_FA_2020_37651_68320.jpg

concrete headwall on LS toe.

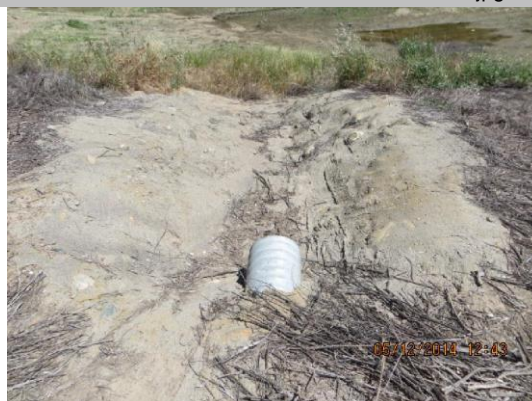
Photo 1 of 3 : UCIP_FA_2020_53498_68319.jpg

Comment Code						
Inspector Comment						
DS_ID:23612 FS_ID:53498 EP_NO: N/A Repair Type: Urgent EVAL Issue: Crossing Status: Found UCIP Comments: 09/18/2018 Levee is so short that it's almost nonexistent. Pipe goes just under levee and acts as an open storm drain. Inlet is bent down. There is a flooding potential because this pipe is open and goes straight through the levee; therefore, this crossing remains "Urgent." (A. McDonald - DWR UCIP)04/20/2017 Pipe is open on both ends. Requires a positive closure device. Crossing has been upgraded from No Action Needed to Urgent. (K. Fazel - UCIP) FIELD_STRUCT_DESC: 12-inch corrugated metal drainage culvert through the levee, 1.5 feet below the crown. Cobble grouted spillway. Open on both ends. [Additional Reference(s): DWR Levee Log, 1987. USACE San Joaquin O&M Manual 612.2, 1967, (HLM 16.10)]. FS Date: 9/18/2018

Pipe visible on WS slope with grouted spillway.

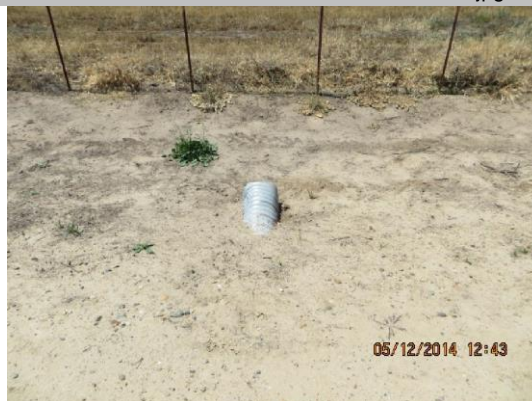
Photo 2 of 3 : UCIP_FA_2020_53498_68318.jpg

Pipe at inlet on LS toe.

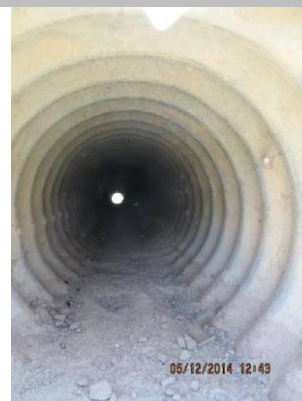
Photo 3 of 3 : UCIP_FA_2020_53498_68317.jpg

Inside pipe at LS toe.

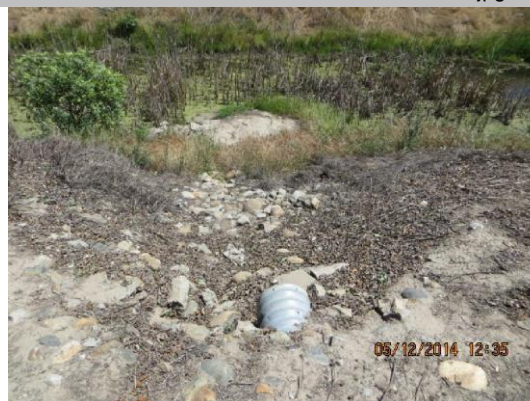
Photo 1 of 3 : UCIP_FA_2020_53499_68316.jpg

DS_ID:23614
 FS_ID:53499
 EP_NO: N/A
 Repair Type: Urgent
 EVAL Issue:
 Crossing Status: Found
 UCIP Comments: 09/18/2018 Levee is so short that it's almost nonexistent. Pipe goes just under levee and acts as an open storm drain. There is a flooding potential because this pipe is open and goes straight through the levee; therefore, this crossing remains "Urgent." (A. McDonald - DWR UCIP)04/20/2017 Pipe is open on both ends. Requires a positive closure device. Crossing has been upgraded from No Action Needed to Urgent. (K. Fazel - UCIP)
 FIELD_STRUCT_DESC: 12-inch corrugated metal drainage culvert through the levee, 2 feet below the crown. Cobble grouted spillway. Open on both ends. [Additional Reference(s): DWR Levee Log, 1987. USACE San Joaquin O&M Manual 612.2, 1967, (HLM 16.32)].
 FS Date: 9/18/2018

Pipe on WS slope.

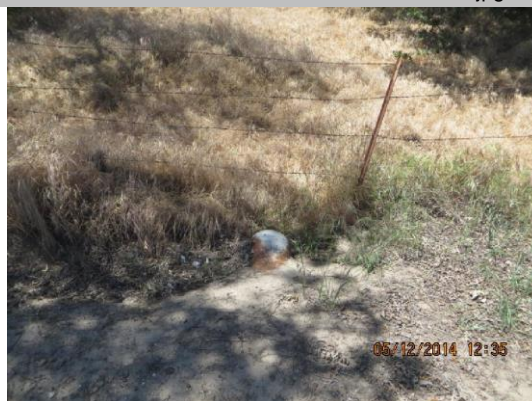
Photo 2 of 3 : UCIP_FA_2020_53499_68315.jpg

Pipe at inlet on LS shoulder.

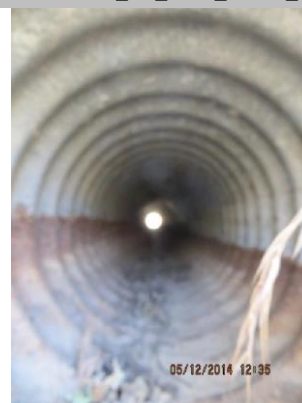
Photo 3 of 3 : UCIP_FA_2020_53499_68314.jpg

Inside pipe at LS inlet.

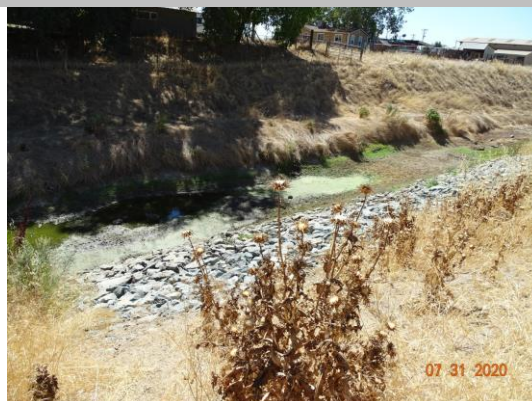
Photo 1 of 3 : SJR2019_NA0017U07RM23.14_01.JPG

*This area is patrol road only and therefore the site is not rated
07/31/2020: The erosion has been repaired since the previous inspection and will be monitored for two years. The repair is 85 ft long and approximately 25 ft high.

08/01/2019: The erosion has cut into the patrol road and may impact access if not repaired. The erosion has likely been caused by surface runoff.

7/31/2020: Looking down the levee slope at the upstream end of the repair.

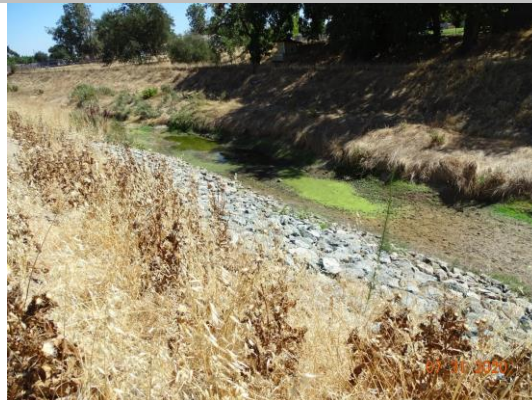
Photo 2 of 3 : SJR2019_NA0017U07RM23.14_02.JPG

7/31/2020: View of the erosion repair from the levee crown.

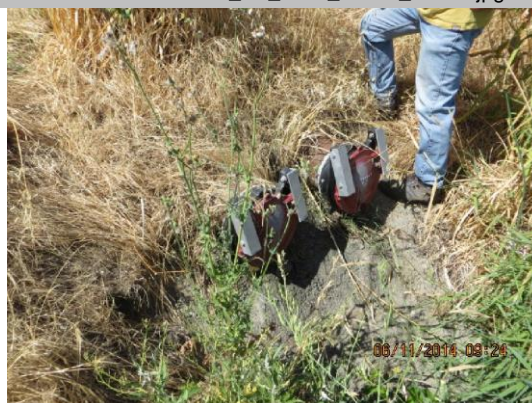
Photo 3 of 3 : UCIP_FA_2020_38523_70513.jpg

flapgate on WS slope.

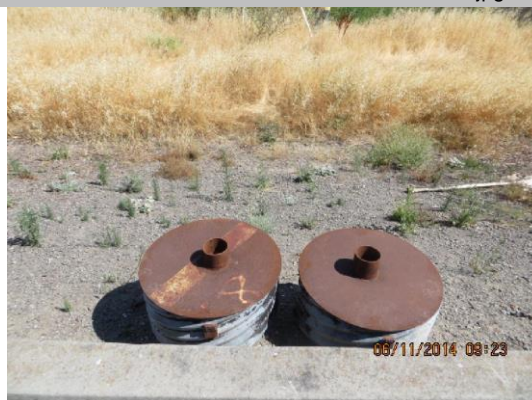
Photo 2 of 3 : UCIP_FA_2020_38524_70517.jpg

siphon breaker visible in 24-inch CMP riser on WS shoulder.

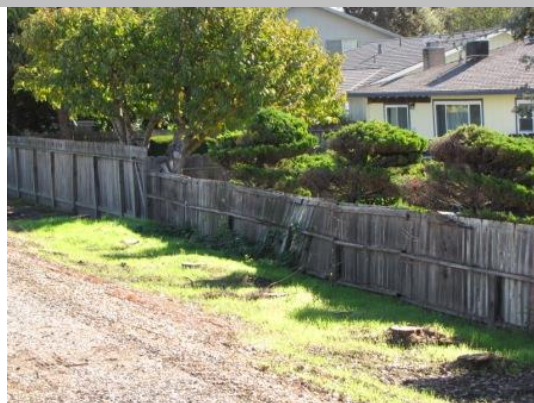
Photo 1 of 1 : FA_2020_NA0017_152_12_20200901_00002.jpg

View of stumps along the landward toe looking upstream.

LM Start	2.50	Rating **	N	Issue No.	12
LM End	2.50	Issue Type +	Ma	Location *	LS
Category	Earthen Levee			GPS Latitude/Longitude	
				Start	End
Item	Trim / Thin Trees			38.042749 °	38.042749 °
				-121.338402 °	-121.338402 °
DWR ID	DWR_NA0017_08_s_2012_12				
Comment Code					
T5 : Tree stumps.					
Inspector Comment

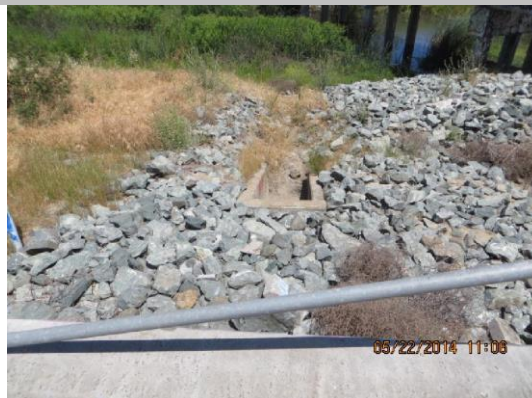
Photo 2 of 3 : UCIP_FA_2020_38510_70477.jpg

Headwall and flapgate at WS toe.

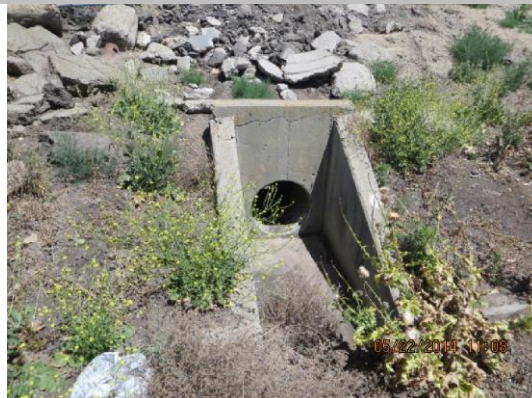
Photo 3 of 3 : UCIP_FA_2020_38510_70476.jpg

Headwall at LS toe.

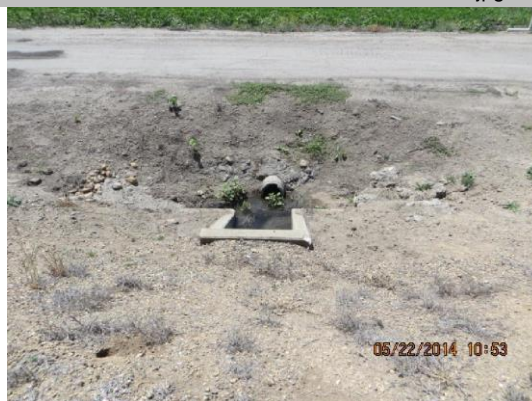
Photo 1 of 3 : UCIP_FA_2020_38507_70468.jpg

Headwall at LS toe.

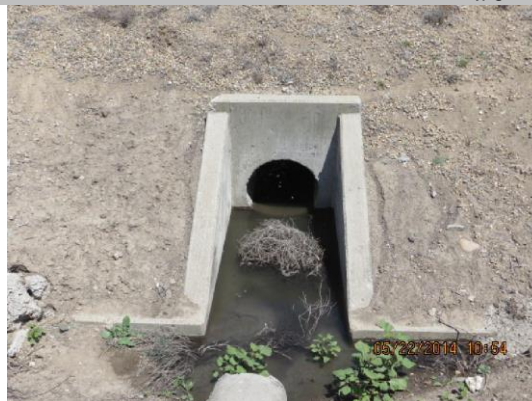
Photo 3 of 3 : UCIP_FA_2020_38507_70466.jpg

Headwall at LS toe.

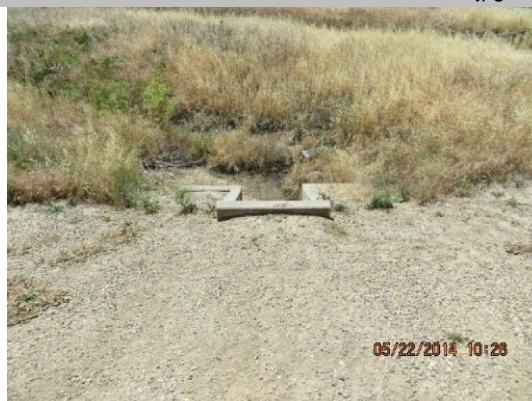
Photo 1 of 3 : UCIP_FA_2020_38477_70362.jpg

Headwall at LS toe.

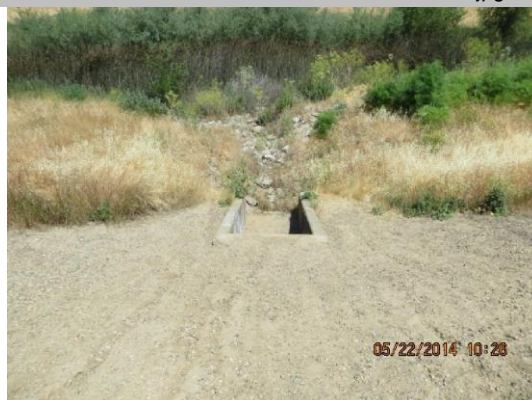
Photo 2 of 3 : UCIP_FA_2020_38477_70361.jpg

Headwall, flapgate, and grouted spillway on WS slope.

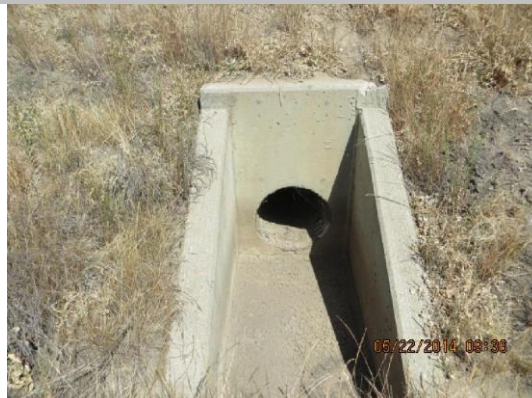
Photo 3 of 3 : UCIP_FA_2020_38444_70289.jpg

Headwall on LS toe.

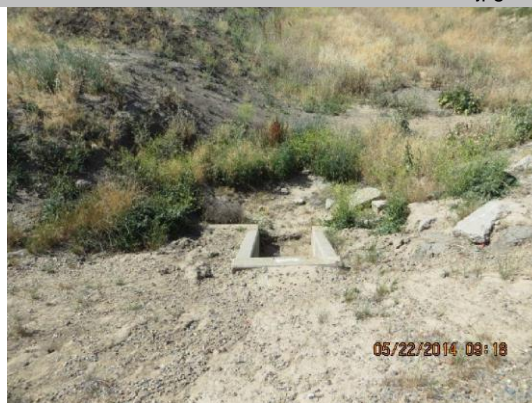
Photo 1 of 3 : UCIP_FA_2020_38427_70280.jpg

Headwall on LS toe.

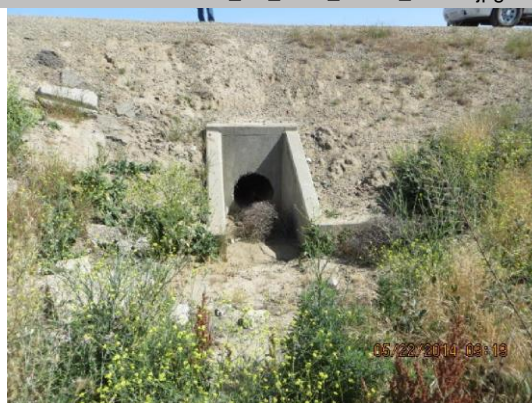
Photo 3 of 3 : UCIP_FA_2020_38427_70278.jpg

Headwall on LS toe.

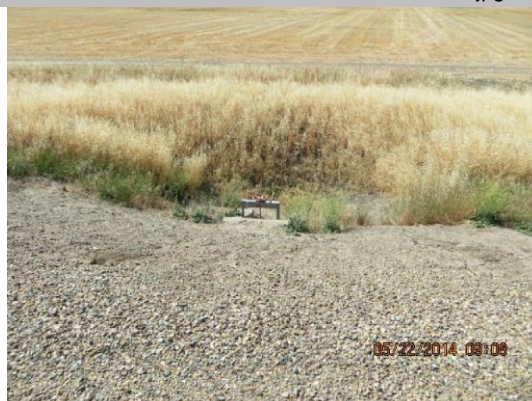
Photo 1 of 3 : UCIP_FA_2020_38373_70038.jpg

Headwall and slidegate on LS toe.

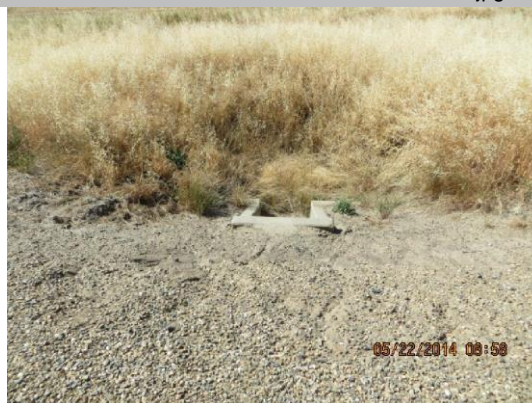
Photo 1 of 3 : UCIP_FA_2020_38368_70029.jpg

Headwall on LS toe.

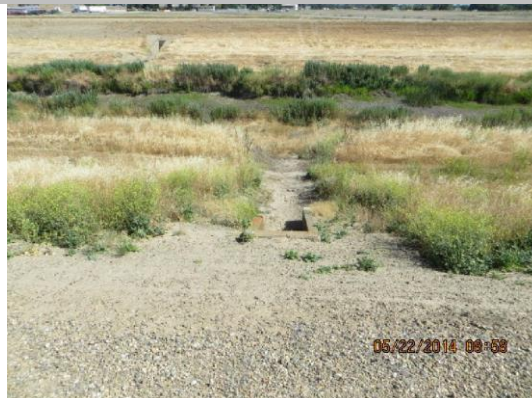
Photo 2 of 3 : UCIP_FA_2020_38368_70028.jpg

Headwall, flapgate, and grouted spillway on WS toe.

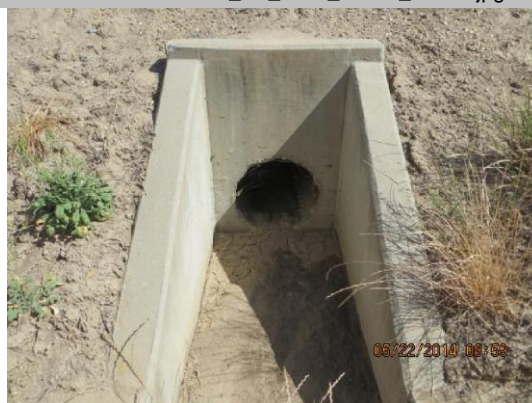
Photo 3 of 3 : UCIP_FA_2020_38368_70027.jpg

Headwall on LS toe.

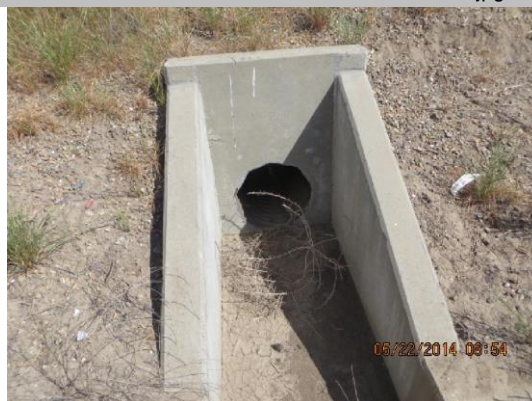
Photo 3 of 3 : UCIP_FA_2020_38367_70022.jpg

Headwall on LS toe.

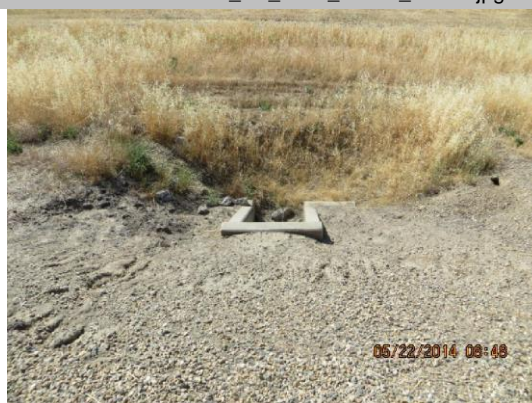
Photo 1 of 3 : UCIP_FA_2020_38365_70019.jpg

Headwall on LS toe.

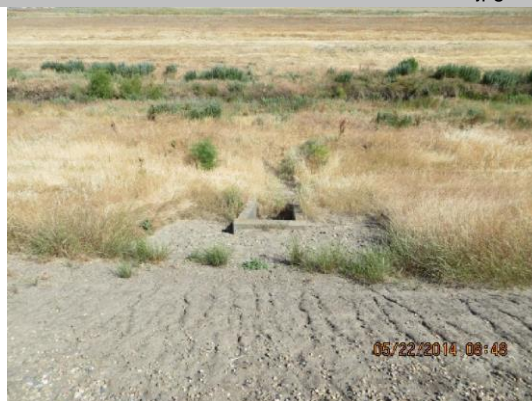
Photo 2 of 3 : UCIP_FA_2020_38365_70018.jpg

Headwall, flapgate, and grouted spillway on WS toe.

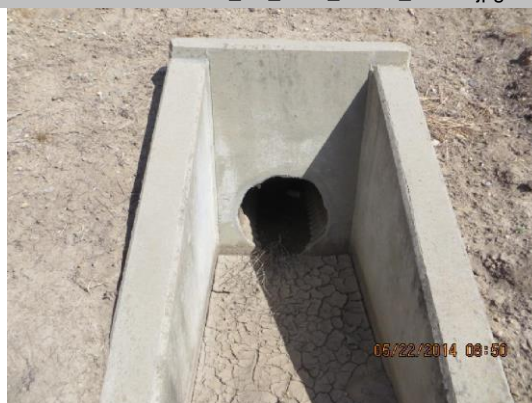
Photo 3 of 3 : UCIP_FA_2020_38365_70017.jpg

Headwall on LS toe.

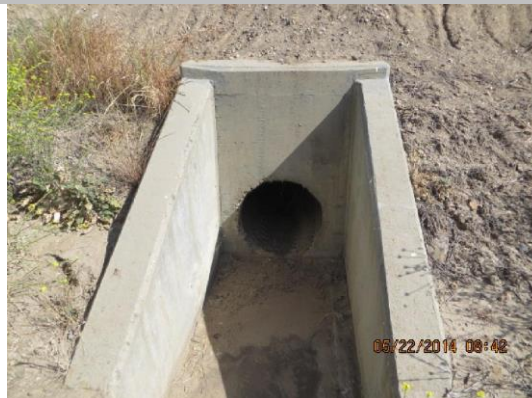
Photo 3 of 3 : UCIP_FA_2020_38363_70008.jpg

Headwall on LS toe.

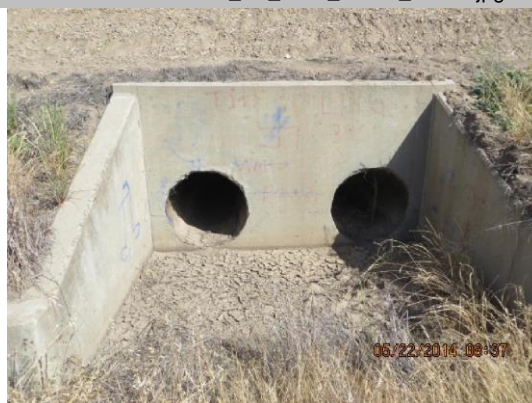
Photo 3 of 3 : UCIP_FA_2020_38361_70003.jpg

Headwall on LS toe.

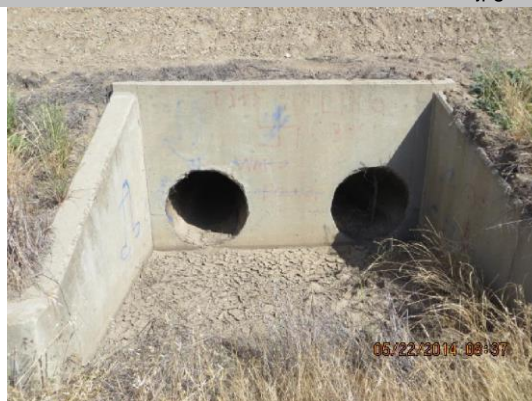
Photo 3 of 3 : UCIP_FA_2020_38360_69998.jpg

Headwall on LS toe.

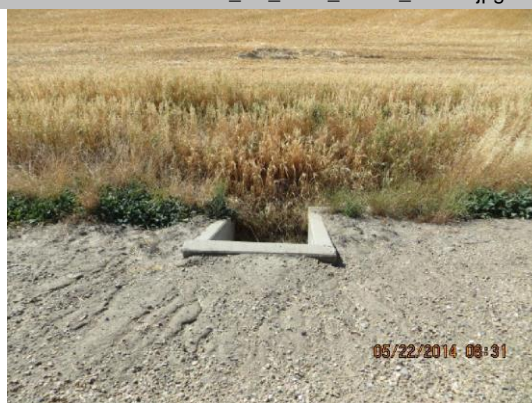
Photo 1 of 3 : UCIP_FA_2020_38359_69995.jpg

Headwall on LS toe.

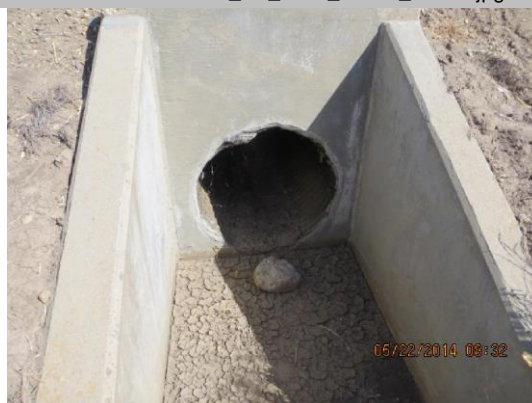
Photo 3 of 3 : UCIP_FA_2020_38359_69993.jpg

Headwall on LS toe.

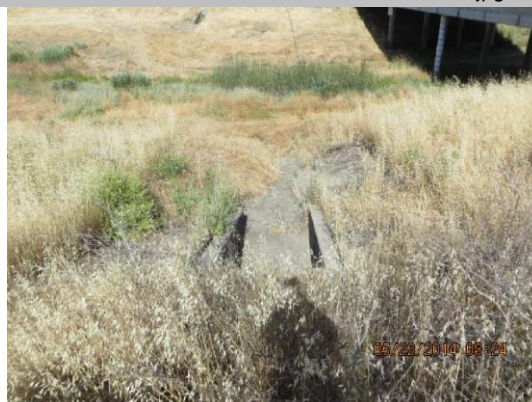
Photo 2 of 3 : UCIP_FA_2020_38358_69989.jpg

Headwall and flapgate on WS slope.

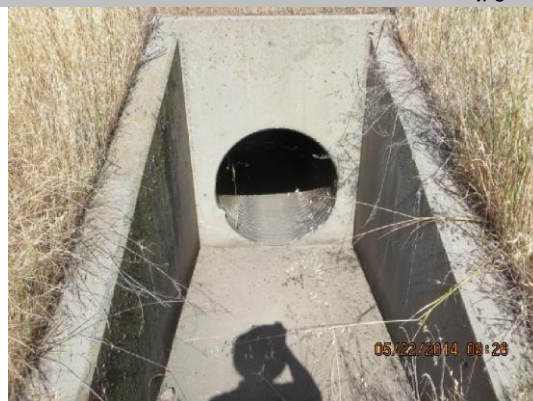
Photo 3 of 3 : UCIP_FA_2020_38358_69988.jpg

Headwall on LS toe.

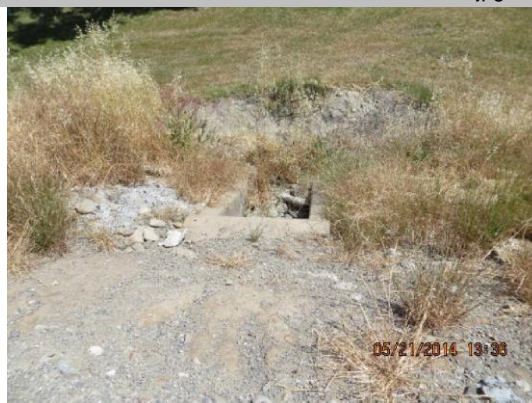
Photo 1 of 3 : UCIP_FA_2020_41809_69980.jpg

Comment Code						
Inspector Comment						
DS_ID:23743						
FS_ID:41809						
EP_NO: N/A						
Repair Type: Non-Urgent						
EVAL Issue:						
Crossing Status: Found						
UCIP Comments: Cobbles building up at inlet and inside pipe along with sediment.						
FIELD_STRUCT_DESC: 24-inch corrugated metal storm drainage pipe through the levee, 7 feet below the crown. Flap gate on the waterside (WS) end. Concrete U-shaped headwalls on both ends. Cobble grouted spillway across the berm. Cobble grouted apron on the landside (LS) end. [Additional Reference(s): DWR Levee Log, 1990. USACE San Joaquin O&M Manual 612.2, 1967, (HLM 7.65) and 612 (addendum), February 1999, (HLM 7.70) (Station 406+58)].						
FS Date: 5/21/2014

Concrete headwall on LS toe.

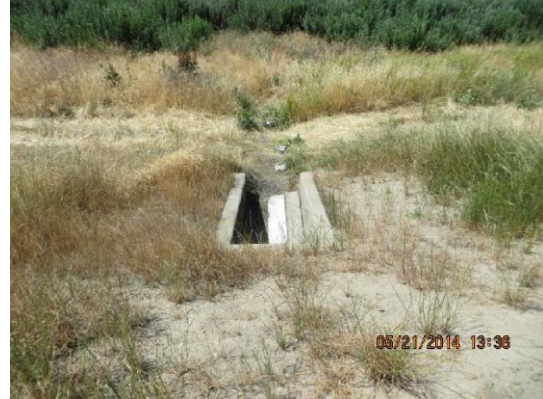
Photo 2 of 3 : UCIP_FA_2020_41809_69979.jpg

Concrete headwall and flapgate at WS toe.

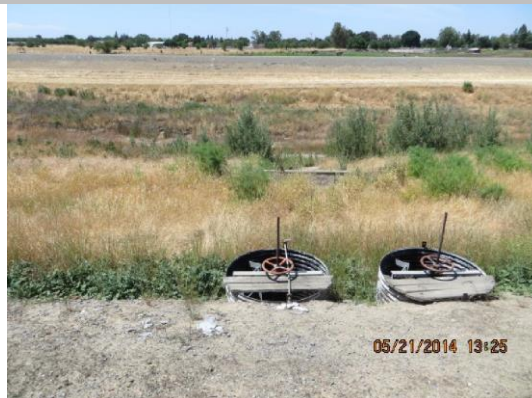
Photo 1 of 3 : UCIP_FA_2020_38352_69974.jpg

Comment Code						
Inspector Comment						
DS_ID:23744						
FS_ID:38352						
EP_NO: N/A						
Repair Type: Non-Urgent						
EVAL Issue:						
Crossing Status: Found						
UCIP Comments: Lid damaged/missing from CMP riser on WS slope.						
FIELD_STRUCT_DESC: 1 of 2: 36-inch corrugated metal storm						
drainage pipe through the levee, 9 feet below the crown. Flap gate on						
the waterside (WS) end. Slide gate in 48-inch corrugated metal riser						
unit on the WS slope. Concrete U-shaped headwalls on both ends.						
Cobble grouted spillway on the channel bank. Cobble grouted apron in						
ditch on the landside (LS). [Additional Reference(s): DWR Levee Log,						
1990. USACE San Joaquin O&M Manual 612.2, 1967, (HLM 8.18) and						
612 (addendum), February 1999, (HLM 8.21) (Station 433+70)].						
FS Date: 5/21/2014

Slide gate in CMP riser on WS slope. Lid missing/damaged.

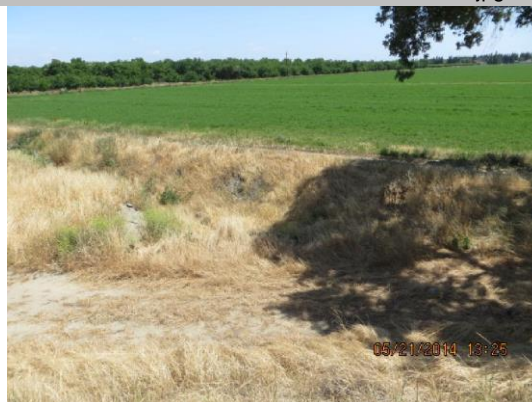
Photo 2 of 3 : UCIP_FA_2020_38352_69973.jpg

Headwall at drainage channel on LS toe.

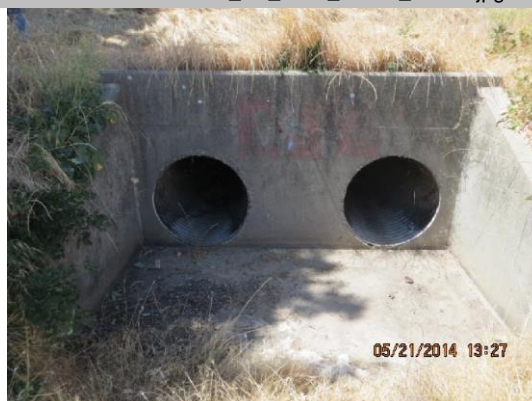
Photo 3 of 3 : UCIP_FA_2020_38351_69966.jpg

Headwall on LS toe at drainage channel.

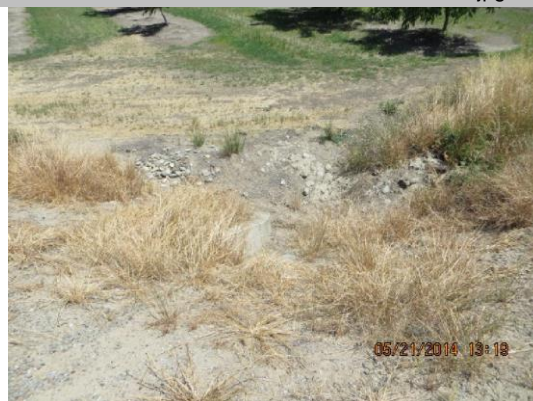
Photo 1 of 3 : UCIP_FA_2020_38350_69963.jpg

Headwall and grouted apron on LS toe.

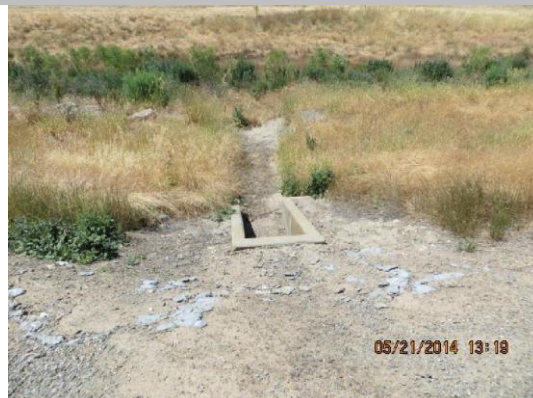
Photo 2 of 3 : UCIP_FA_2020_38350_69962.jpg

Headwall, flapgate, and grouted spillway on WS toe.

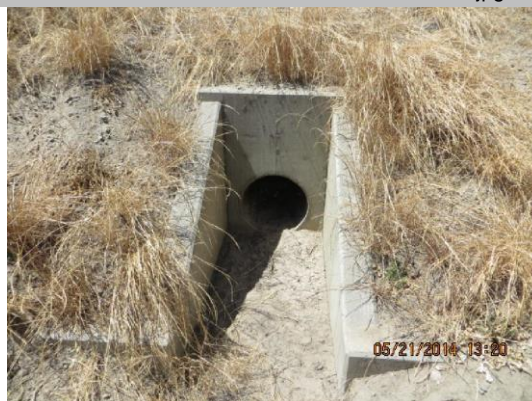
Photo 3 of 3 : UCIP_FA_2020_38350_69961.jpg

Headwall on LS toe.

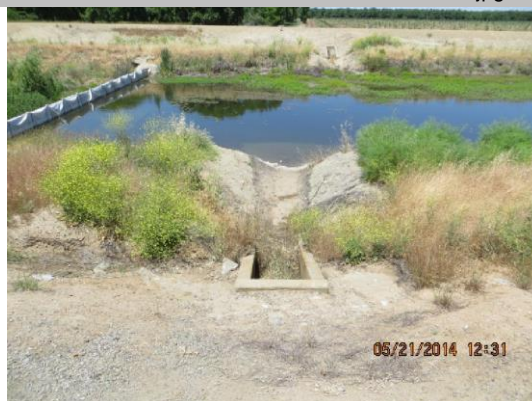
Photo 1 of 3 : UCIP_FA_2020_38241_69739.jpg

Headwall, flapgate, and grouted spillway on WS slope.

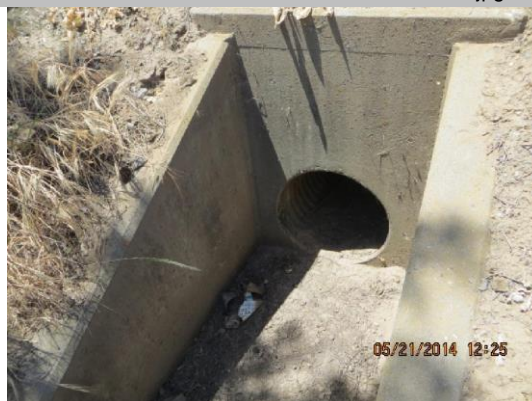
Photo 3 of 3 : UCIP_FA_2020_38239_69726.jpg

Headwall at LS toe.

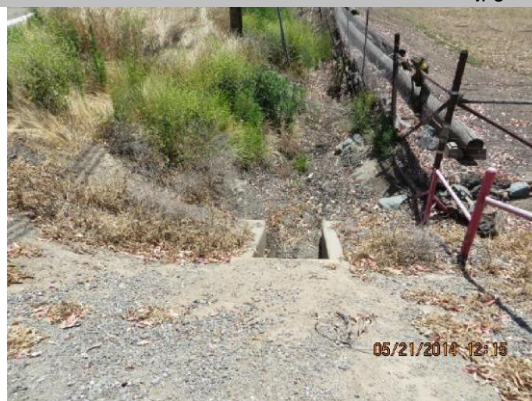
Photo 1 of 3 : UCIP_FA_2020_38232_69706.jpg

Headwall on LS toe.

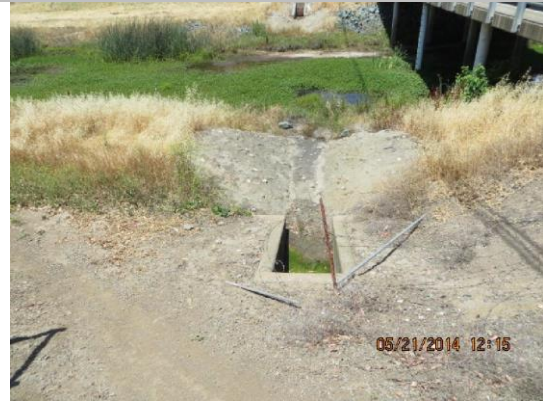
Photo 2 of 3 : UCIP_FA_2020_38232_69705.jpg

Headwall, flapgate, and grouted spillway on WS slope.

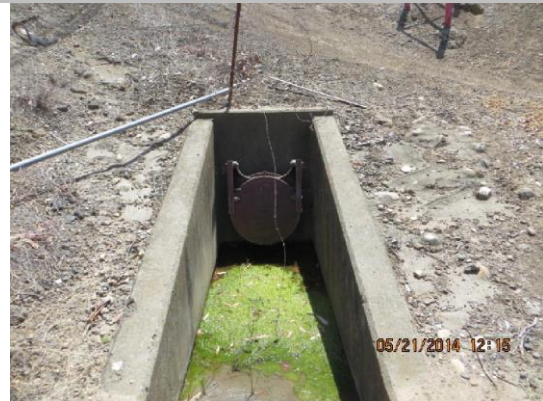
Photo 3 of 3 : UCIP_FA_2020_38232_69704.jpg

Headwall and flapgate on WS slope.

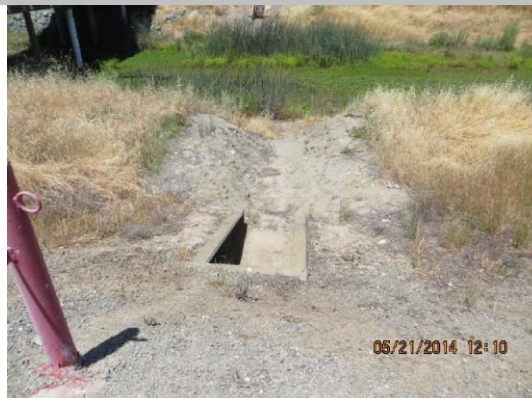
Photo 2 of 3 : UCIP_FA_2020_41808_69700.jpg

Headwall, flapgate, and grouted spillway on WS slope.

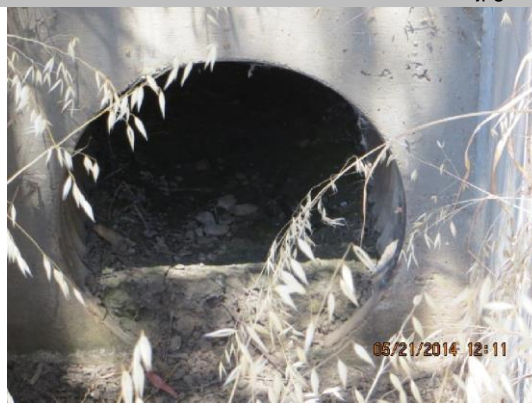
Photo 3 of 3 : UCIP_FA_2020_41808_69703.jpg

Headwall at LS toe.

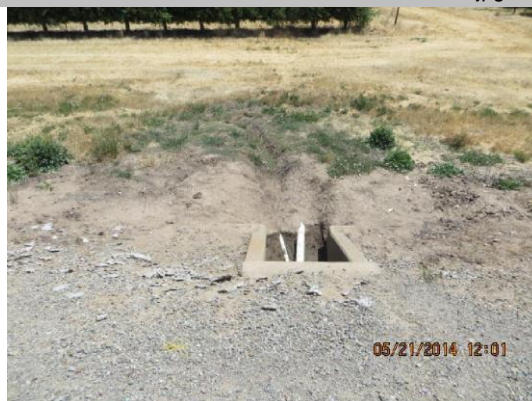
Photo 1 of 3 : UCIP_FA_2020_38229_69693.jpg

Comment Code						
Inspector Comment						
DS_ID:23748						
FS_ID:38229						
EP_NO: N/A						
Repair Type: No Action Needed						
EVAL Issue:						
Crossing Status: Found						
UCIP Comments: 2-small PVC pipes discharge into inlet on LS toe.						
FIELD_STRUCT_DESC: 24-inch corrugated metal storm drainage pipe through the levee, 7 feet below the crown. Flap gate on the waterside (WS) end. Concrete U-shaped headwalls on both ends. Cobble grouted spillway across the berm. Cobble grouted apron on the landside (LS) end. [Additional Reference(s): DWR Levee Log, 1990. USACE San Joaquin O&M Manual 612.2, 1967, (HLM 10.75) and 612 (addendum), February 1999, (HLM 10.72) (Station 566+09)].						
FS Date: 5/21/2014

Headwall with two PVC discharge pipes at LS toe.

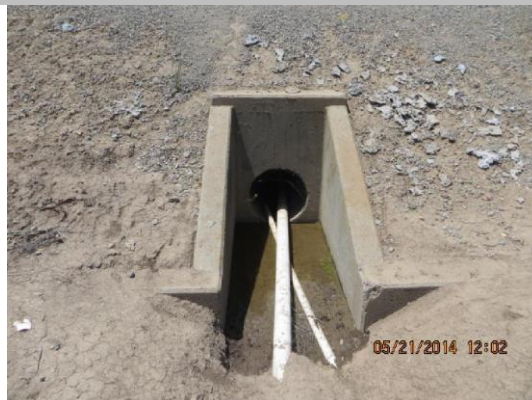
Photo 2 of 3 : UCIP_FA_2020_38229_69692.jpg

Headwall with two PVC discharge pipes at LS toe.

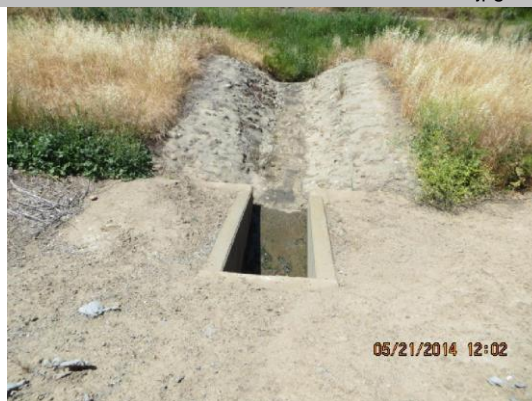
Photo 3 of 3 : UCIP_FA_2020_38229_69691.jpg

Headwall, flapgate, and grouted spillway on WS slope.

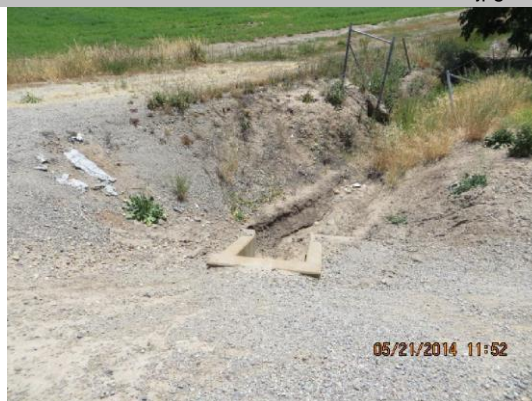
Photo 1 of 3 : UCIP_FA_2020_41810_69684.jpg

Comment Code						
Inspector Comment						
DS_ID:23749						
FS_ID:41810						
EP_NO: N/A						
Repair Type: Non-Urgent						
EVAL Issue:						
Crossing Status: Found						
UCIP Comments: Some silt buildup in pipe at LS toe.						
FIELD_STRUCT_DESC: 24-inch corrugated metal storm drainage pipe through the levee, 8 feet below the crown. Flap gate on the waterside (WS) end. Concrete U-shaped headwalls on both ends. Cobble grouted spillway across the berm. Cobble grouted apron on the landside (LS) end. [Additional Reference(s): DWR Levee Log, 1990. USACE San Joaquin O&M Manual 612.2, 1967, (HLM 10.97) and 612 (addendum), February 1999, (HLM 10.94) (Station 577+59)].						
FS Date: 5/21/2014

Headwall at LS toe.

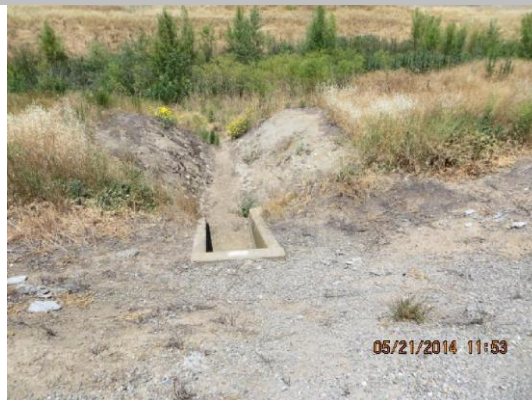
Photo 2 of 3 : UCIP_FA_2020_41810_69683.jpg

Headwall, flapgate, and grouted spillway on WS slope.

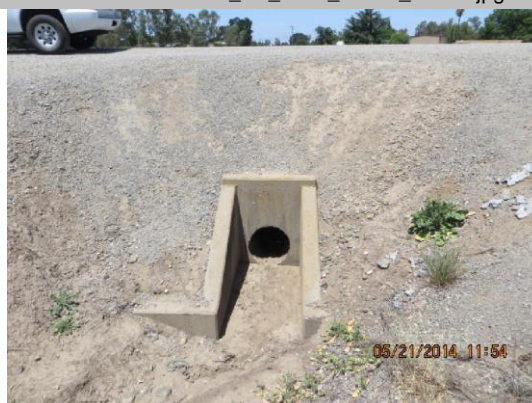
Photo 3 of 3 : UCIP_FA_2020_41810_69682.jpg

Headwall at LS toe.

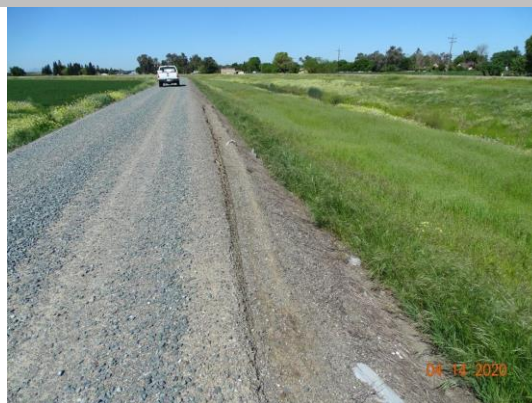
Photo 1 of 1 : FA_2020_NA0017_152_185_20200901_00028.jpg

LM Start	10.85	Rating **	M	Issue No.	185
LM End	10.85	Issue Type +	Ma	Location *	WS
Category	Earthen Levee			GPS Latitude/Longitude	
				Start	End
Item	Slope Stability			38.079060 °	38.079060 °
				-121.202462 °	-121.202462 °
DWR ID	DWR_NA0017_08_s_2020_185				
Comment Code					
S3 : Repair the levee slope damaged by vehicle traffic and prevent access where possible.					
Inspector Comment

View of tire ruts on waterside hinge. Spring 2020

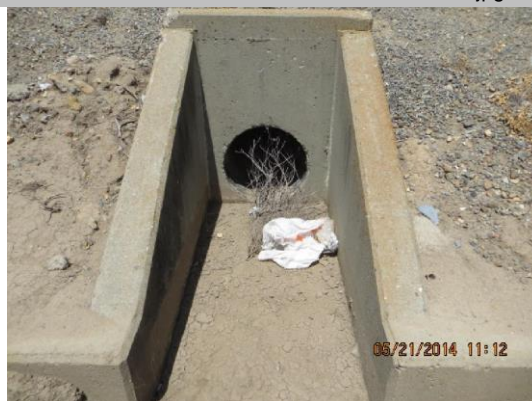
Photo 3 of 3 : UCIP_FA_2020_38224_69665.jpg

Headwall at LS toe.

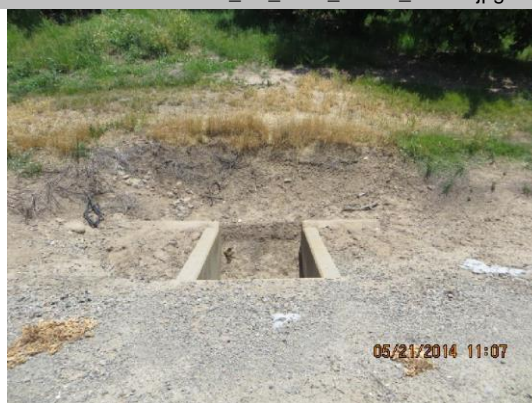
Photo 1 of 3 : UCIP_FA_2020_38223_69662.jpg

Headwall and grouted intake on LS toe.

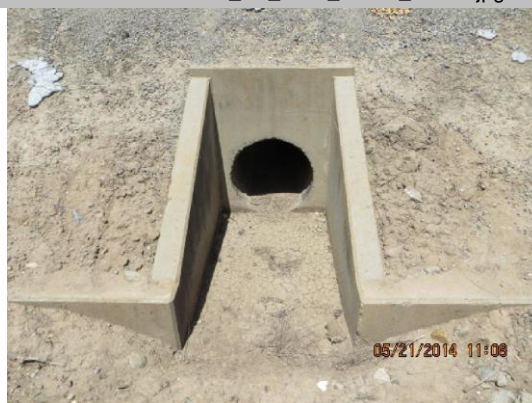
Photo 3 of 3 : UCIP_FA_2020_38223_69660.jpg

Headwall on LS toe.

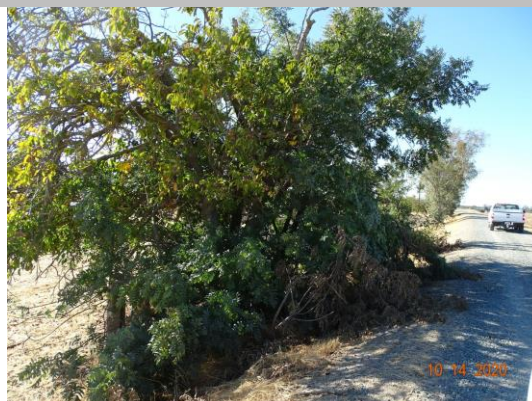
Photo 1 of 1 : FA_2020_NA0017_152_148_20201019_00315.jpg

LM Start	11.20	Rating **	U	Issue No.	148
LM End	11.20	Issue Type +	Ma	Location *	LS
Category	Earthen Levee			GPS Latitude/Longitude	
				Start	End
Item	Trim / Thin Trees			38.082320 °	38.082320 °
				-121.197916 °	-121.197916 °
DWR ID	DWR_NA0017_08_f_2019_148				
Comment Code					
T3 : Trim and thin trees to allow visibility of the ground and room to flood fight.					
Inspector Comment

View of untrimmed tree on landside slope. Fall 2020

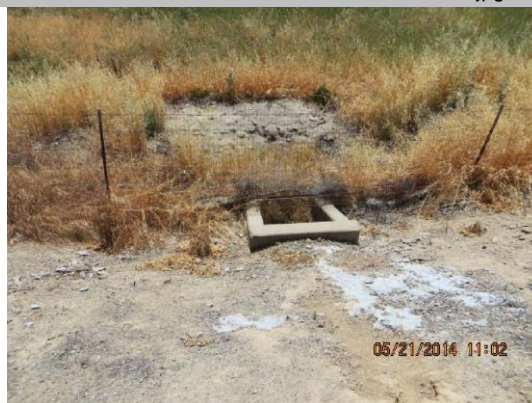
Photo 1 of 3 : UCIP_FA_2020_38221_69659.jpg

Headwall at LS toe with grouted inlet.

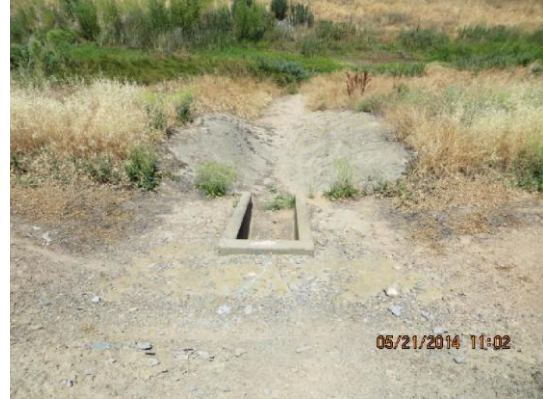
Photo 2 of 3 : UCIP_FA_2020_38221_69658.jpg

Headwall, flapgate, and grouted spillway on WS slope.

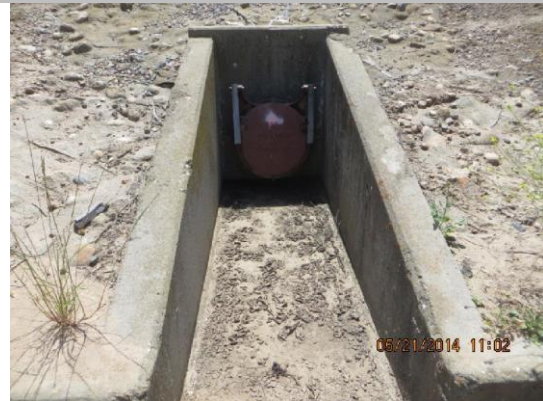
Photo 3 of 3 : UCIP_FA_2020_38221_69657.jpg

Headwall and flapgate on WS slope.

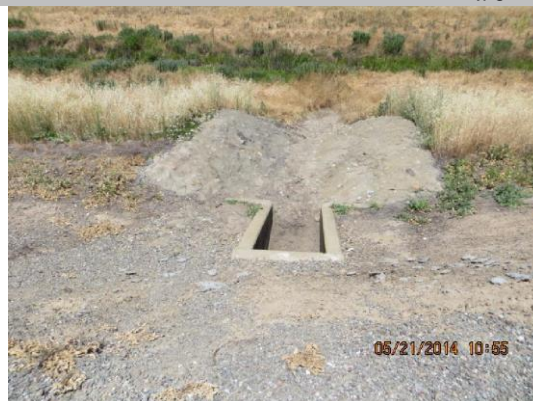
Photo 2 of 3 : UCIP_FA_2020_51700_69652.jpg

Headwall, flapgate, and grouted spillway on WS slope.

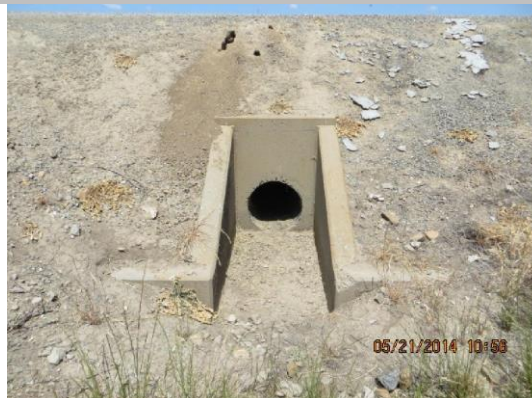
Photo 3 of 3 : UCIP_FA_2020_51700_69651.jpg

Headwall on LS toe.

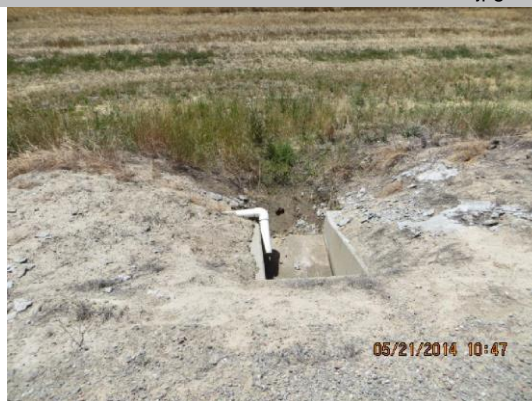
Photo 1 of 3 : UCIP_FA_2020_51701_69648.jpg

Headwall at LS toe. 4-inch PVC backwash from filter plant discharges at headwall.

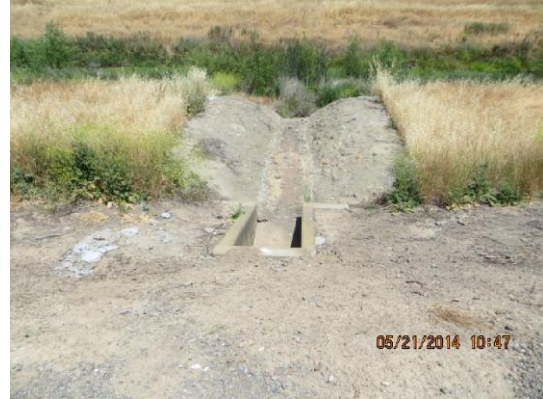
Photo 2 of 3 : UCIP_FA_2020_51701_69647.jpg

Headwall, flapgate, and grouted spillway on WS slope.

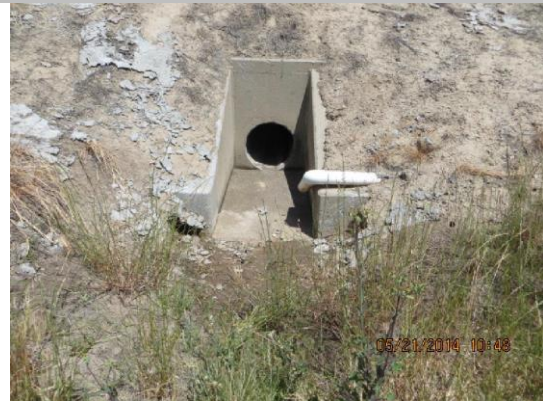
Photo 3 of 3 : UCIP_FA_2020_51701_69646.jpg

Headwall on LS toe.

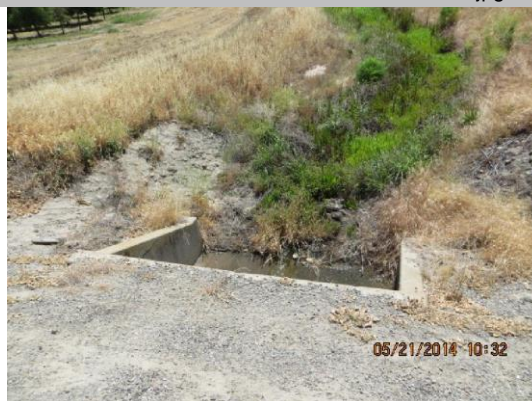
Photo 1 of 3 : UCIP_FA_2020_38216_69639.jpg

Headwall on LS toe.

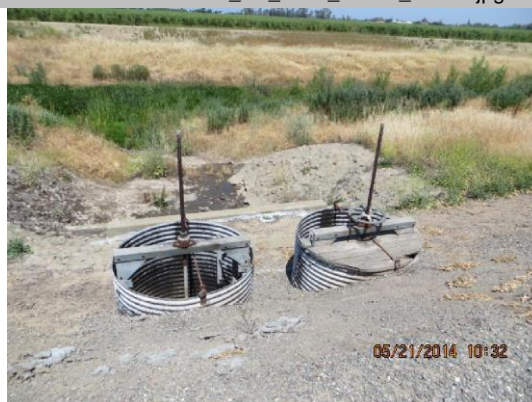
Photo 2 of 3 : UCIP_FA_2020_38216_69638.jpg

Comment Code						
Inspector Comment						
DS_ID:23756						
FS_ID:38216						
EP_NO: N/A						
Repair Type: Non-Urgent						
EVAL Issue:						
Crossing Status: Found						
UCIP Comments: CMP riser missing cover on WS slope.						
FIELD_STRUCT_DESC: 1 of 2: 48-inch corrugated metal storm drainage pipe through the levee, 8.5 feet below the crown. Slide gate in 60-inch corrugated metal riser unit on the waterside (WS) slope. Concrete U-shaped headwalls on both ends. Cobble grouted spillway on the WS end. Cobble grouted apron on the landside (LS) end. [Additional Reference(s): DWR Levee Log, 1990. USACE San Joaquin O&M Manual 612.2, 1967, (HLM 12.20) and 612 (addendum), February 1999, (HLM 12.13) (Station 640+50)].						
FS Date: 5/21/2014

Slide gate in CMP riser on WS slope missing cover.

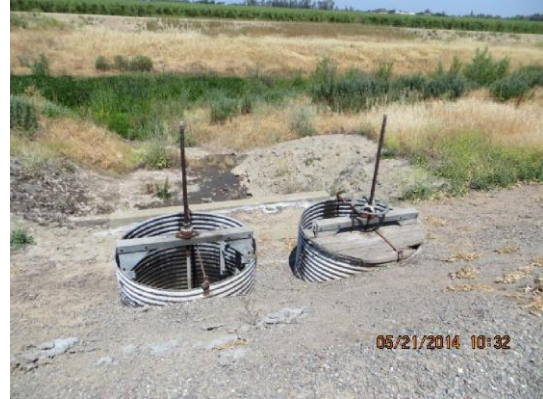
Photo 2 of 3 : UCIP_FA_2020_38214_69624.jpg

Slidegate on WS shoulder.

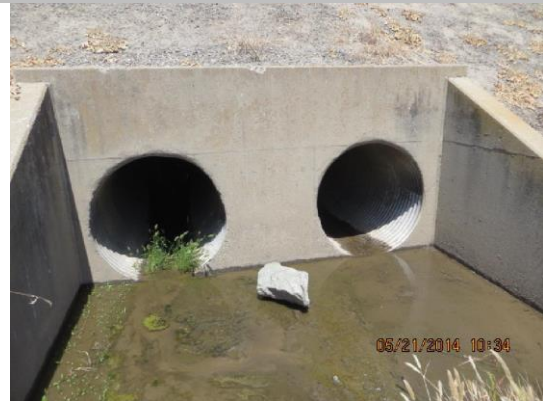
Photo 3 of 3 : UCIP_FA_2020_38214_69623.jpg

Headwall on LS toe.

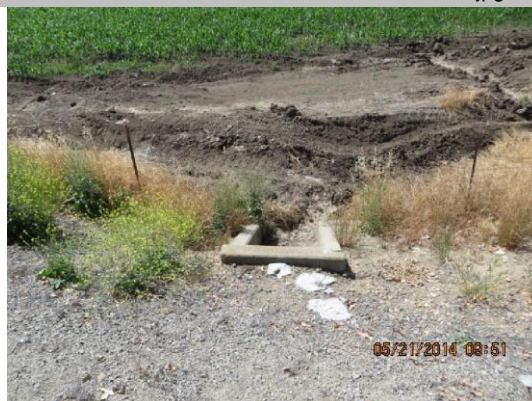
Photo 1 of 3 : UCIP_FA_2020_38210_69610.jpg

Headwall on LS toe.

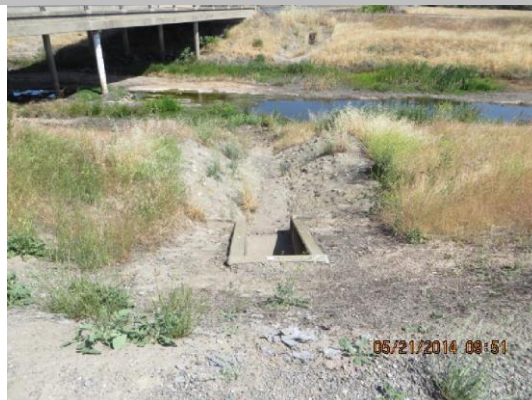
Photo 2 of 3 : UCIP_FA_2020_38210_69609.jpg

Headwall, flapgate, and grouted spillway on WS slope.

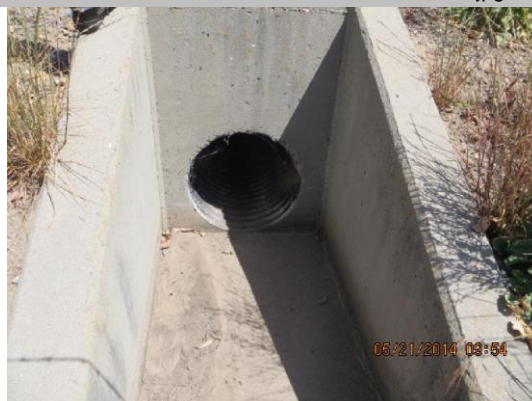
Photo 3 of 3 : UCIP_FA_2020_38210_69608.jpg

Headwall on LS toe.

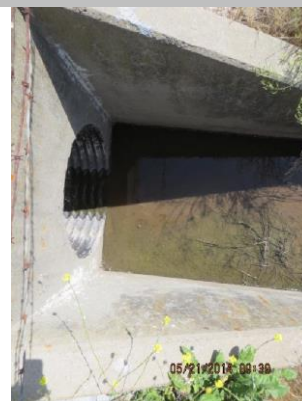
Photo 3 of 3 : UCIP_FA_2020_38206_69600.jpg

Headwall at LS toe.

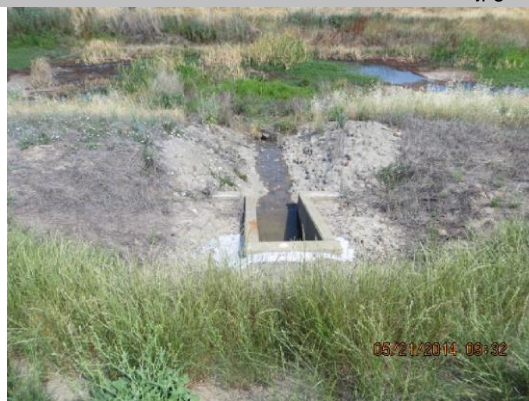
Photo 1 of 3 : UCIP_FA_2020_38205_69591.jpg

Headwall, flapgate, and grouted spillway on WS slope.

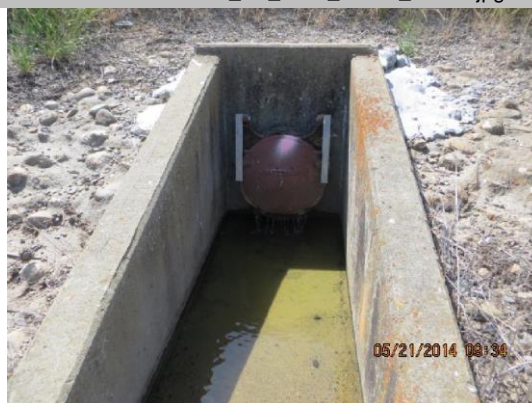
Photo 3 of 3 : UCIP_FA_2020_38205_69589.jpg

Headwall and Flapgate on WS slope.
