**Flood Control Project Maintenance
Levee Inspections**

Maintenance Issue Types Only, Levee Inspection Report By Mile - Fall 2020

San Joaquin County Flood Control and Water Conservation District

Waterway	Bank	Unit Miles	Inspection Start/End	Inspector
Unit No. 01 Littlejohn Creek	Left	2.59	10/20/2020 10/20/2020	Alberto De Leon

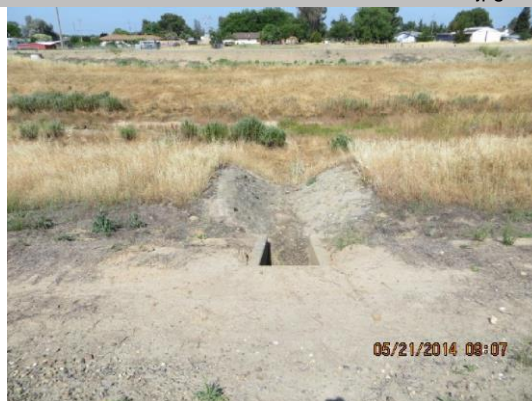
Photo 2 of 3 : UCIP_FA_2020_38203_69581.jpg

Headwall, flapgate, and grouted spillway on WS slope.

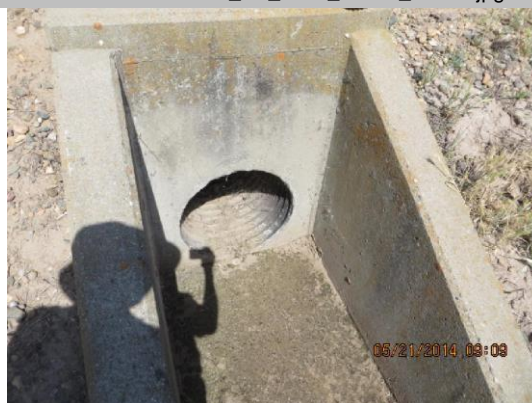
Photo 3 of 3 : UCIP_FA_2020_38203_69580.jpg

Concrete headwall on LS toe.

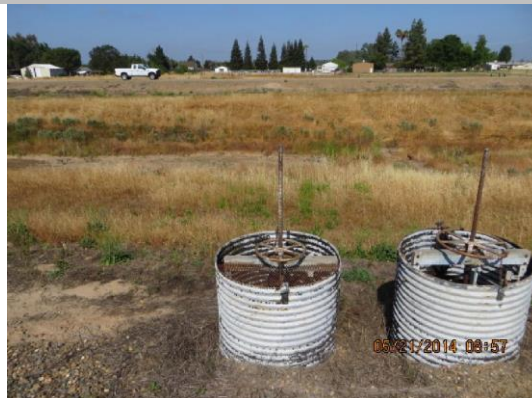
Photo 1 of 3 : UCIP_FA_2020_38144_69426.jpg

Slidegate in CMP riser on WS slope.

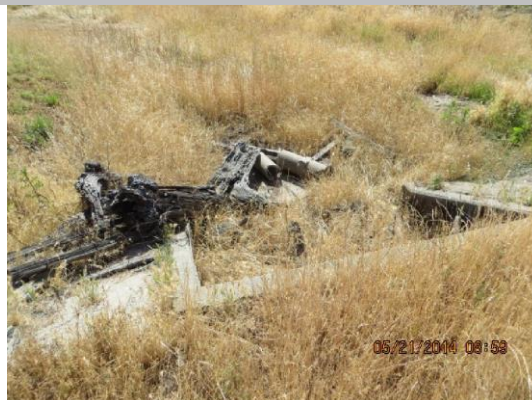
Photo 2 of 3 : UCIP_FA_2020_38144_69425.jpg

Headwall on LS toe. Note debris buildup.

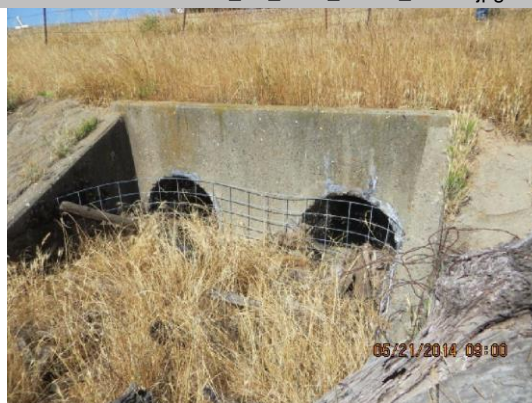
Photo 3 of 3 : UCIP_FA_2020_38143_69420.jpg

Headwall on LS toe. Note debris buildup.

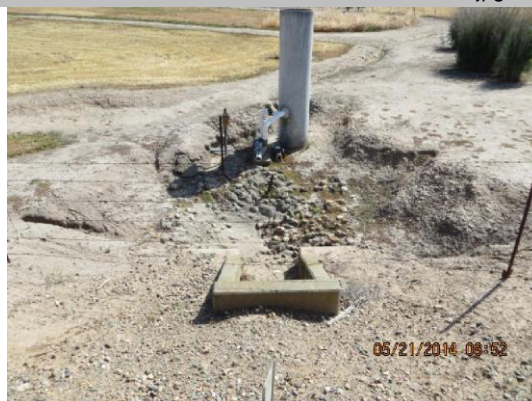
Photo 1 of 3 : UCIP_FA_2020_38141_69418.jpg

Headwall on LS toe.

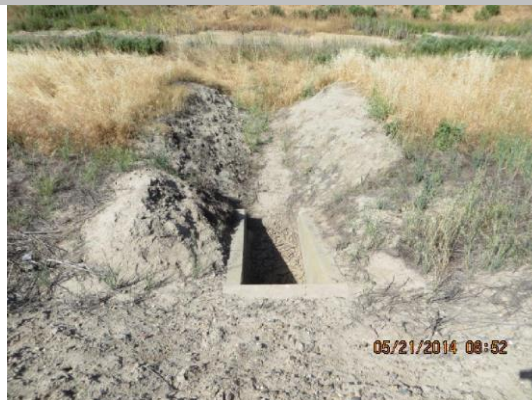
Photo 2 of 3 : UCIP_FA_2020_38141_69417.jpg

Headwall, flapgate, and grouted spillway on WS slope.

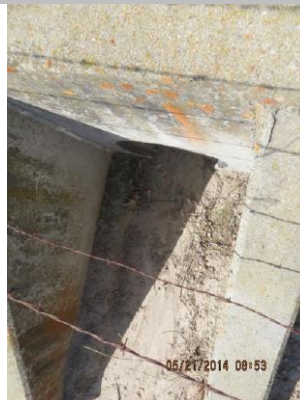
Photo 3 of 3 : UCIP_FA_2020_38141_69416.jpg

Headwall on LS toe.

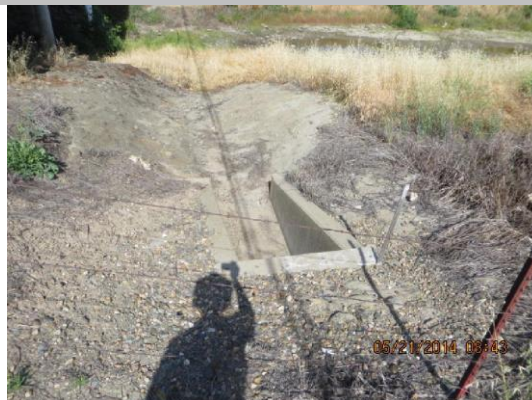
Photo 2 of 3 : UCIP_FA_2020_38140_69412.jpg

Headwall, flapgate, and grouted spillway on WS slope.

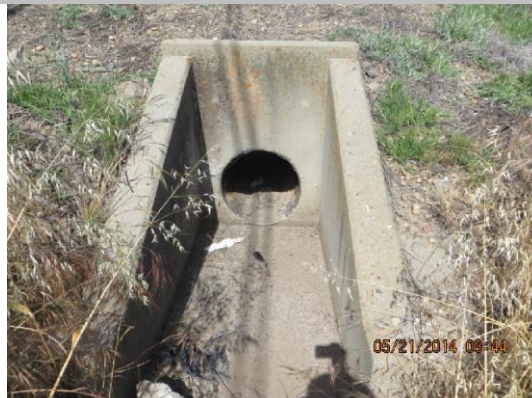
Photo 3 of 3 : UCIP_FA_2020_38140_69411.jpg

Headwall on LS toe.

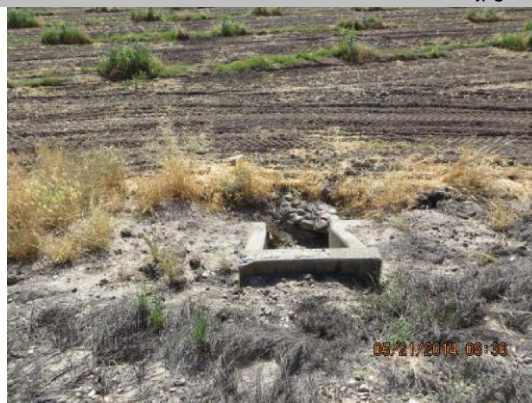
Photo 1 of 3 : UCIP_FA_2020_38139_69408.jpg

DS_ID:23771
 FS_ID:38139
 EP_NO: N/A
 Repair Type: No Action Needed
 EVAL Issue:
 Crossing Status: Found
 UCIP Comments:
 FIELD_STRUCT_DESC: 24-inch corrugated metal drainage pipe through the levee, 6 feet below the crown. Concrete U-shaped headwall on both ends. Flap gate on the waterside (WS) end. Cobble grouted spillway. Cobble grouted intake on the landside (LS). [Additional Reference(s): DWR Levee Log, 1990. USACE San Joaquin O&M Manual 612.2, 1967, (HLM 13.81)].
 FS Date: 5/21/2014

Headwall on LS toe.

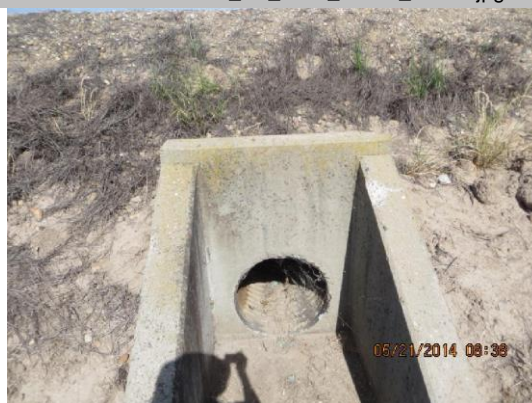
Photo 3 of 3 : UCIP_FA_2020_38139_69406.jpg

Headwall on LS toe.

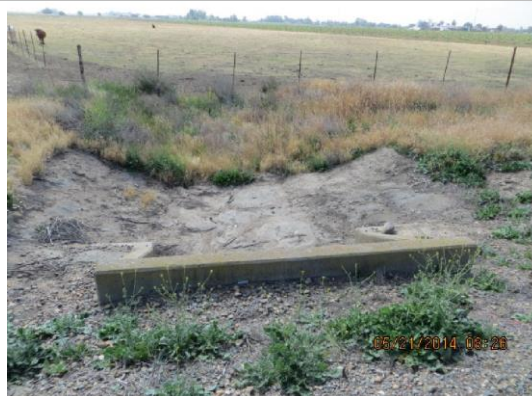
Photo 2 of 3 : UCIP_FA_2020_38137_69400.jpg

Headwall on LS toe.

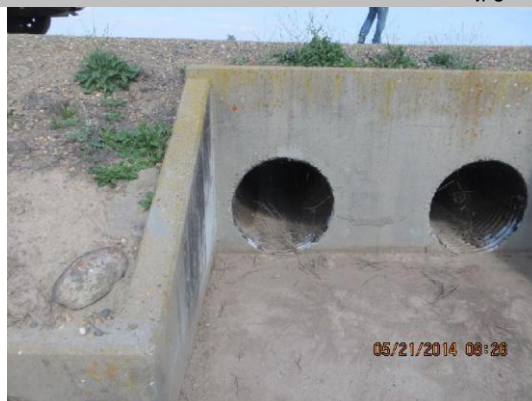
Photo 3 of 3 : UCIP_FA_2020_38137_69399.jpg

Headwall on LS toe.

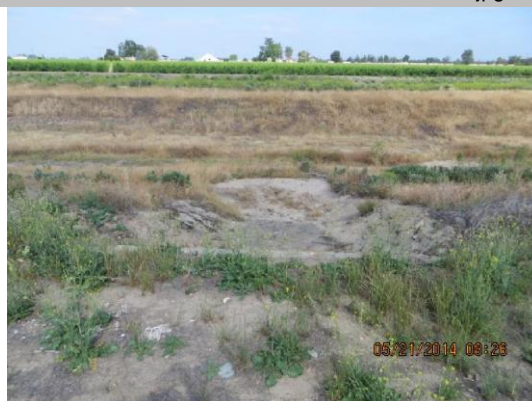
Photo 1 of 3 : UCIP_FA_2020_38136_69396.jpg

DS_ID:23815
 FS_ID:38136
 EP_NO: N/A
 Repair Type: No Action Needed
 EVAL Issue:
 Crossing Status: Found
 UCIP Comments:
 FIELD_STRUCT_DESC: 2 of 2: 36-inch corrugated metal drainage pipe through the levee, 4 feet below the crown. Concrete U-shaped headwall on both ends. Flap gate on the waterside (WS) end. Cobble grouted spillway. Cobble grouted intake on the landside (LS). [Additional Reference(s): DWR Levee Log, 1990. USACE San Joaquin O&M Manual 612.2, 1967, (HLM 14.16)].
 FS Date: 5/21/2014

Headwall and flapgate on WS slope.

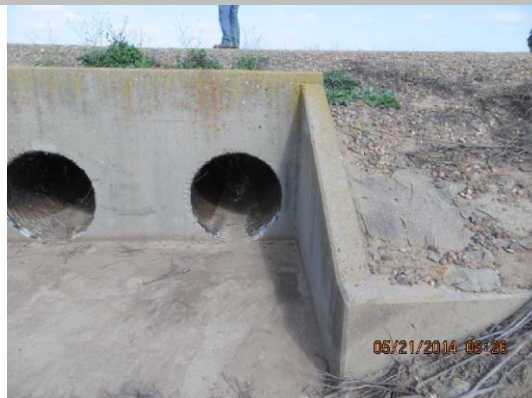
Photo 3 of 3 : UCIP_FA_2020_38136_69394.jpg

Headwall on LS toe.

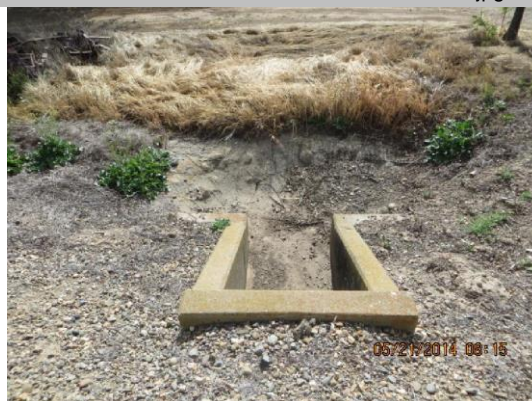
Photo 1 of 3 : UCIP_FA_2020_38134_69389.jpg

LM Start	13.97	Rating **	A/W	Issue No.	1188	
LM End	13.97	Issue Type +	Ma	Location *		
Category	Supplemental			GPS Latitude/Longitude		
				Start		End
Item	DWR UCIP LMA Responsibility			38.111250 °		38.111250 °
				-121.172202 °		-121.172202 °
DWR ID	23775					
Comment Code						
Inspector Comment						
DS_ID:23775						
FS_ID:38134						
EP_NO: N/A						
Repair Type: No Action Needed						
EVAL Issue:						
Crossing Status: Found						
UCIP Comments:						
FIELD_STRUCT_DESC: 24-inch corrugated metal drainage pipe through the levee, 4 feet below the crown. Concrete U-shaped headwall on both ends. Flap gate on the waterside (WS) end. Cobble grouted spillway. Cobble grouted intake on the landside (LS). [Additional Reference(s): DWR Levee Log, 1990. USACE San Joaquin O&M Manual 612.2, 1967, (HLM 14.35)].						
FS Date: 5/21/2014

Headwall at LS toe.

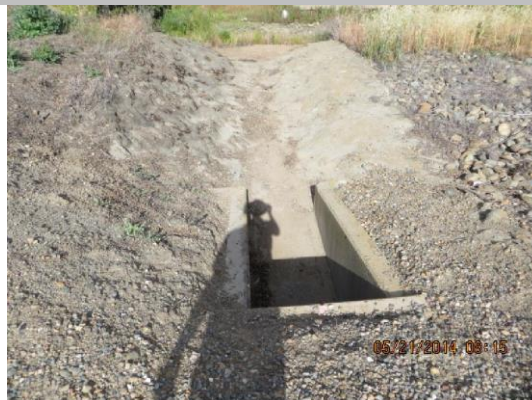
Photo 2 of 3 : UCIP_FA_2020_38134_69388.jpg

Headwall, flapgate, and grouted spillway on WS slope.

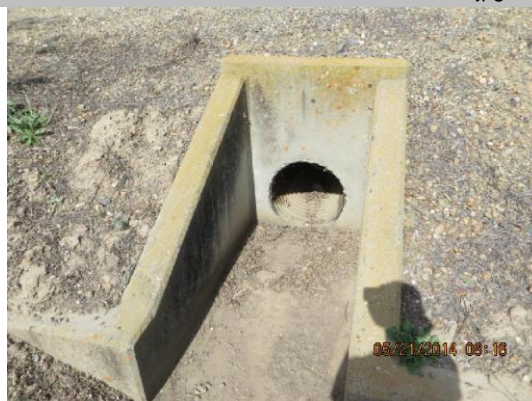
Photo 3 of 3 : UCIP_FA_2020_38134_69387.jpg

Headwall at LS toe.

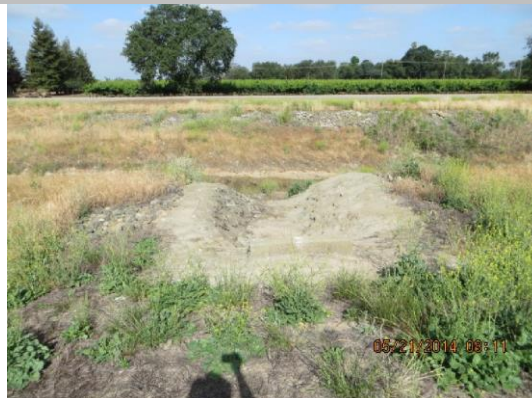
Photo 2 of 3 : UCIP_FA_2020_38133_69383.jpg

Headwall, flapgate, and grouted spillway on WS slope.

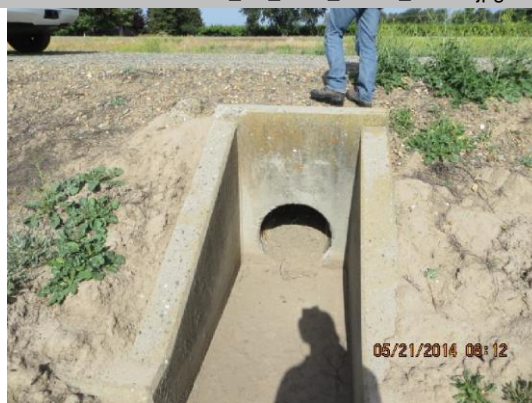
Photo 3 of 3 : UCIP_FA_2020_38133_69382.jpg

Headwall on LS toe.

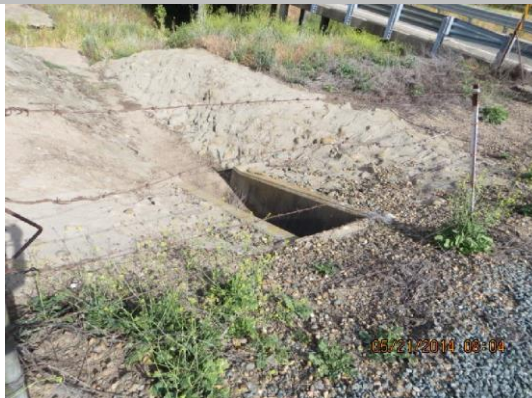
Photo 1 of 3 : UCIP_FA_2020_38130_69375.jpg

LM Start	14.31	Rating **	M	Issue No.	1190	
LM End	14.31	Issue Type +	Ma	Location *		
Category	Supplemental			GPS Latitude/Longitude		
				Start		End
Item	DWR UCIP LMA Responsibility			38.116164 °		38.116164 °
				-121.171657 °		-121.171657 °
DWR ID	23778					
Comment Code						
Inspector Comment						
DS_ID:23778						
FS_ID:38130						
EP_NO: N/A						
Repair Type: Non-Urgent						
EVAL Issue:						
Crossing Status: Found						
UCIP Comments: Some silt buildup inside pipe.						
FIELD_STRUCT_DESC: 24-inch corrugated metal drainage pipe through the levee, 4 feet below the crown. Concrete U-shaped headwall on both ends. Flap gate on the waterside (WS) end. Cobble grouted spillway. Cobble grouted intake on the landside (LS). [Additional Reference(s): DWR Levee Log, 1990. USACE San Joaquin O&M Manual 612.2, 1967, (HLM 14.69)].						
FS Date: 5/21/2014

Headwall, flapgate, and grouted spillway on WS slope.

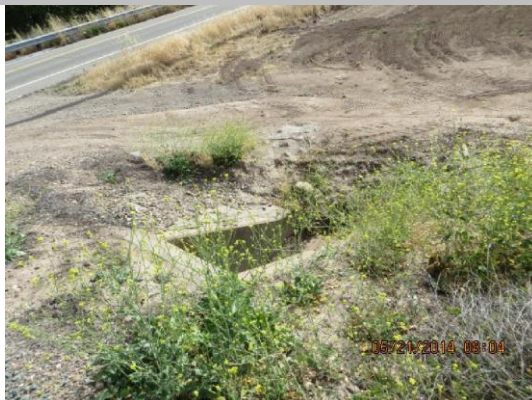
Photo 2 of 3 : UCIP_FA_2020_38130_69374.jpg

Headwall on LS toe.

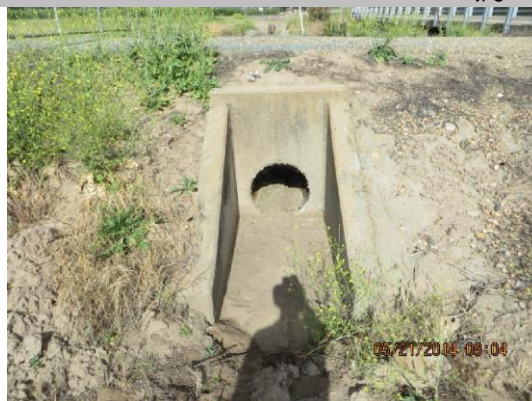
Photo 3 of 3 : UCIP_FA_2020_38130_69373.jpg

Headwall on LS toe.

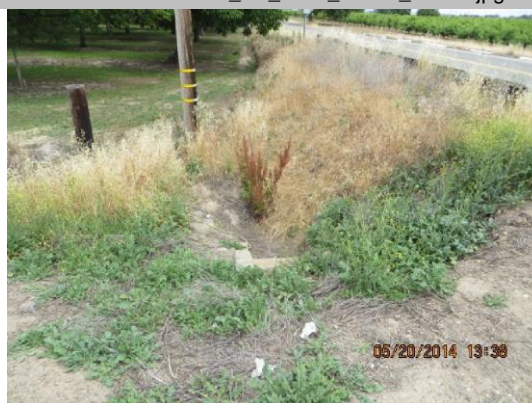
Photo 1 of 3 : UCIP_FA_2020_38129_69370.jpg

DS_ID:23779
 FS_ID:38129
 EP_NO: N/A
 Repair Type: No Action Needed
 EVAL Issue:
 Crossing Status: Found
 UCIP Comments:
 FIELD_STRUCT_DESC: 24-inch corrugated metal drainage pipe through the levee, 6.5 feet below the crown. Concrete U-shaped headwall on both ends. Flap gate on the waterside (WS) end. Cobble grouted spillway. Cobble grouted intake on the landside (LS).
 [Additional Reference(s): DWR Levee Log, 1990. USACE San Joaquin O&M Manual 612.2, 1967, (HLM 14.70)].
 FS Date: 5/20/2014

Headwall on LS toe.

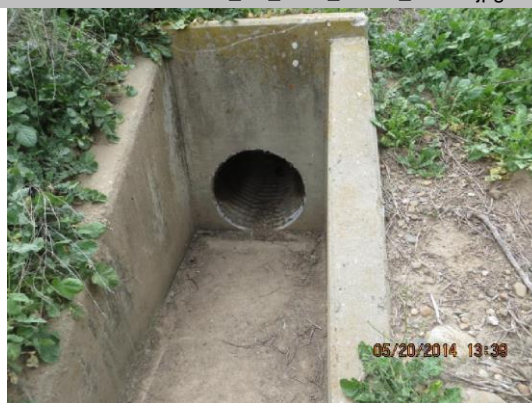
Photo 3 of 3 : UCIP_FA_2020_38129_69368.jpg

Headwall at LS toe.

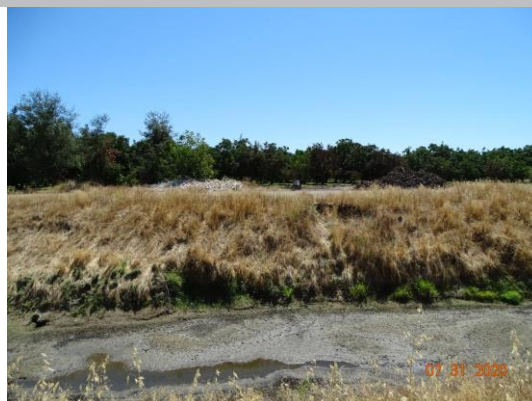
Photo 1 of 2 : SJR2019_NA0017U08RM21.46_01.JPG

LM Start	14.67	Rating **	A/W	Issue No.	2
LM End	14.68	Issue Type +	Ma	Location *	WS
Category	Supplemental			GPS Latitude/Longitude	
				Start	End
Item	DWR Erosion Survey			38.121103 °	38.121103 °
				-121.169363 °	-121.169363 °
DWR ID	NA0017U08RM21.46				
Comment Code					
Inspector Comment					
Site ID: NA0017U08RM21.46					
*This area is patrol road only and therefore the site is not rated					
07/31/2020: Observed two scour locations at the toe, beneath the existing erosion, approximately 5 ft long and 3 to 4 high. Also noticed some signs of burrow activity.					
08/01/2019: Erosion likely has been caused by rainfall runoff.

7/31/2020: View of the erosion and scour holes from the opposite bank.

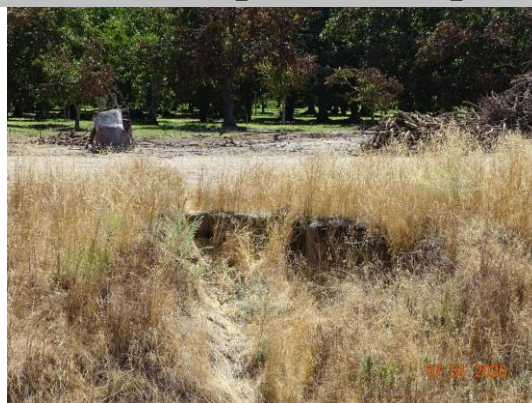
Photo 2 of 2 : SJR2019_NA0017U08RM21.46_03.JPG

7/31/2020: Close-up view of the erosion.

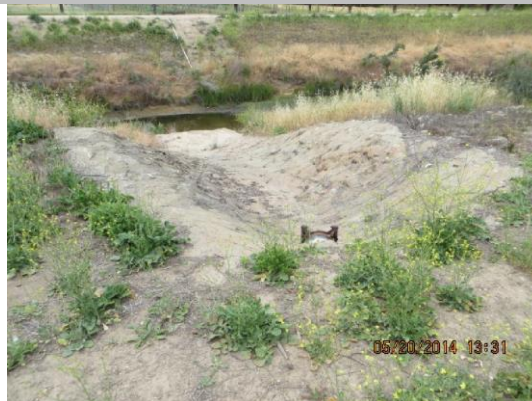
Photo 2 of 3 : UCIP_FA_2020_38127_69361.jpg

Pipe, flapgate, and grouted spillway on WS slope.

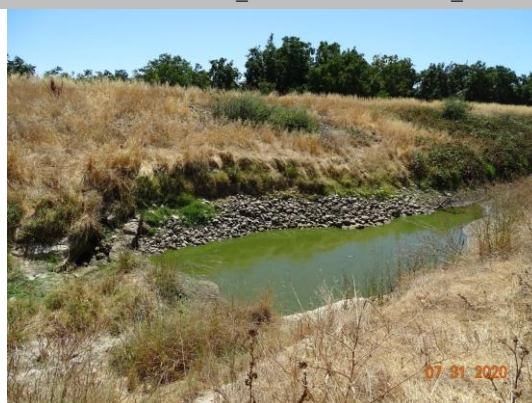
Photo 1 of 3 : SJR2019_NA0017U08RM21.52_02.JPG

*This area is patrol road only and therefore the site is not rated
09/08/2020: Visited a PL84-99 erosion repair (most likely DWR 2017 Storm Damage Site LMA-305) that begins at the downstream end of the erosion site, extending 200 ft downstream on both banks.
07/31/2020: No changes observed since the previous inspection.
08/01/2019: Erosion is at the bank toe, caused by river flow.

7/31/2020: View of the erosion from the opposite bank.

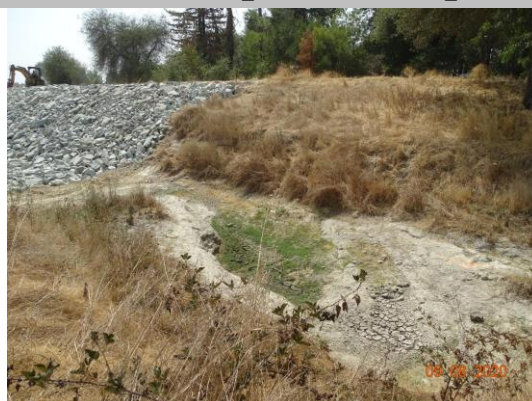
Photo 3 of 3 : SJR2019_NA0017U08RM21.52_11.JPG

9/8/2020: View of the erosion and upstream end of the repair.

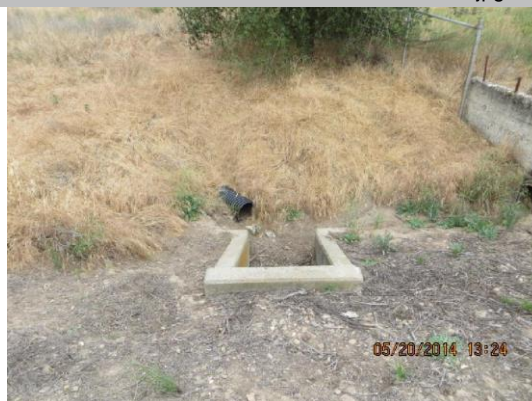
Photo 1 of 3 : UCIP_FA_2020_38126_69357.jpg

LM Start	14.85	Rating **	A/W	Issue No.	1194	
LM End	14.85	Issue Type +	Ma	Location *		
Category	Supplemental			GPS Latitude/Longitude		
				Start		End
Item	DWR UCIP LMA Responsibility			38.123628 °		38.123628 °
				-121.169175 °		-121.169175 °
DWR ID	23781					
Comment Code						
Inspector Comment						
DS_ID:23781 FS_ID:38126 EP_NO: N/A Repair Type: No Action Needed EVAL Issue: Crossing Status: Found UCIP Comments: FIELD_STRUCT_DESC: 24-inch corrugated metal drainage pipe through the levee, 6 feet below the crown. Concrete U-shaped headwall on both ends. Flap gate on the waterside (WS) end. Cobble grouted spillway. Cobble grouted inlet on the landside (LS). [Additional Reference(s): DWR Levee Log, 1990. USACE San Joaquin O&M Manual 612.2, 1967, (HLM 15.24)]. FS Date: 5/20/2014

Headwall at LS toe.

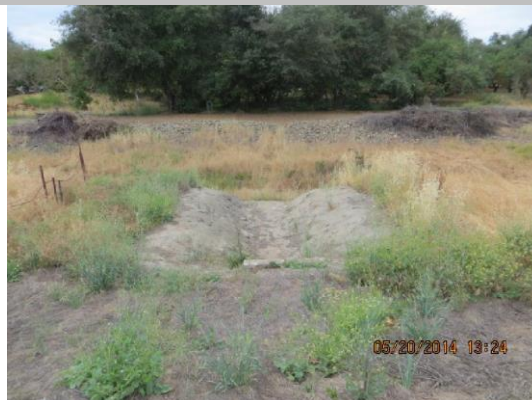
Photo 2 of 3 : UCIP_FA_2020_38126_69356.jpg

Headwall, flapgate, and grouted spillway on WS toe.

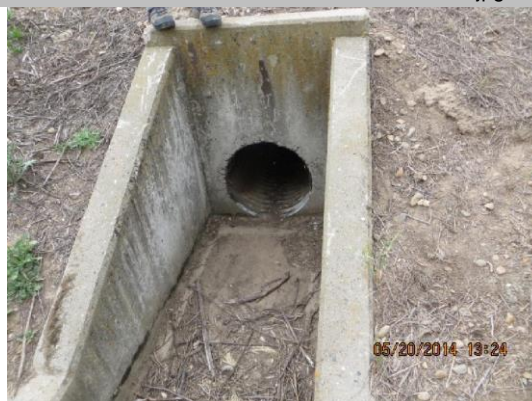
Photo 3 of 3 : UCIP_FA_2020_38126_69355.jpg

Headwall at LS toe.

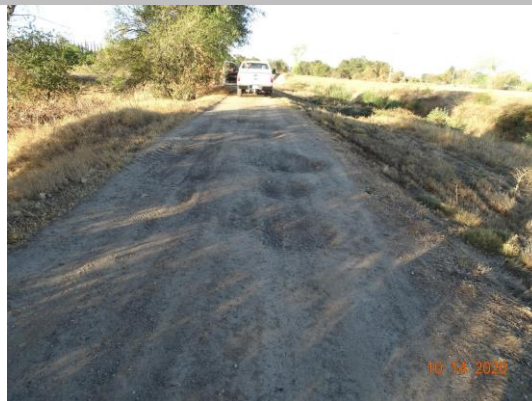
Photo 1 of 1 : FA_2020_NA0017_152_136_20201019_00309.jpg

LM Start	15.05	Rating **	U	Issue No.	136
LM End	15.05	Issue Type +	Ma	Location *	CR
Category	Earthen Levee			GPS Latitude/Longitude	
				Start	End
Item	Crown Surface / Depressions / Rutting			38.125716 °	38.125716 °
				-121.166874 °	-121.166874 °
DWR ID	DWR_NA0017_08_s_2020_136				
Comment Code					
C2 : Repair depressions or ruts in the crown or slope.					
Inspector Comment

View of rutting and depressions on surface road. Fall 2020

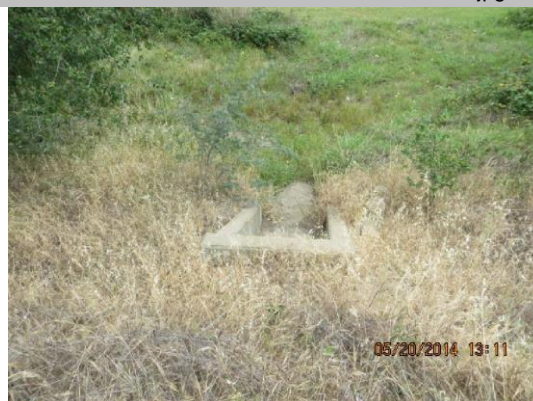
Photo 1 of 3 : UCIP_FA_2020_38125_69352.jpg

LM Start	15.05	Rating **	A/W	Issue No.	1196	
LM End	15.05	Issue Type +	Ma	Location *		
Category	Supplemental			GPS Latitude/Longitude		
				Start		End
Item	DWR UCIP LMA Responsibility			38.125741 °		38.125741 °
				-121.166840 °		-121.166840 °
DWR ID	23782					
Comment Code						
Inspector Comment						
DS_ID:23782						
FS_ID:38125						
EP_NO: N/A						
Repair Type: No Action Needed						
EVAL Issue:						
Crossing Status: Found						
UCIP Comments:						
FIELD_STRUCT_DESC: 24-inch corrugated metal drainage pipe through the levee, 6 feet below the crown. Concrete U-shaped headwall on both ends. Flap gate on the waterside (WS) end. Cobble grouted spillway. Cobble grouted intake on the landside (LS). [Additional Reference(s): DWR Levee Log, 1990. USACE San Joaquin O&M Manual 612.2, 1967, (HLM 15.44)].						
FS Date: 5/20/2014

Headwall at LS toe.

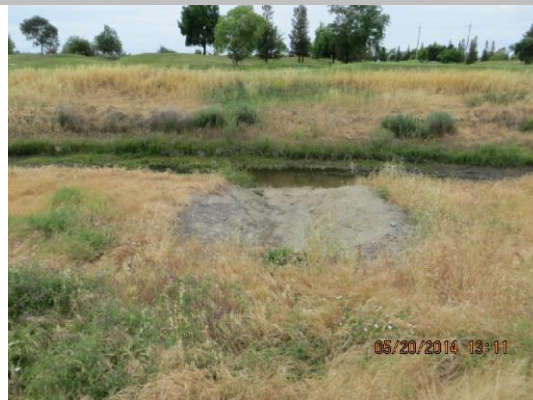
Photo 2 of 3 : UCIP_FA_2020_38125_69351.jpg

Headwall, flapgate, and grouted spillway on WS toe.

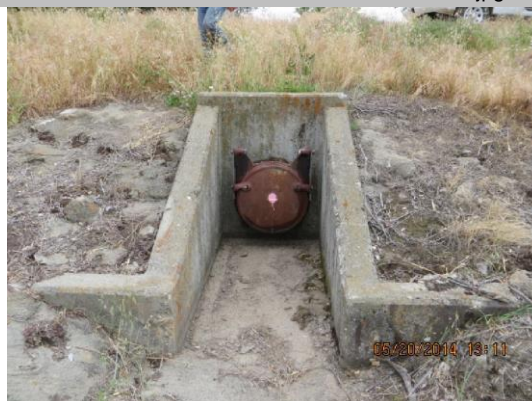
Photo 3 of 3 : UCIP_FA_2020_38125_69350.jpg

Headwall and flapgate at WS toe.

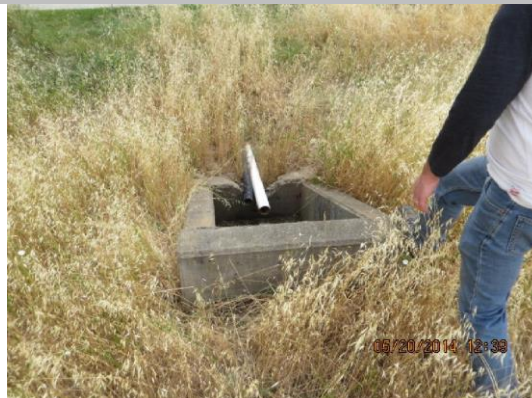
Photo 1 of 3 : UCIP_FA_2020_38122_69342.jpg

LM Start	15.62	Rating **	A/W	Issue No.	1204	
LM End	15.62	Issue Type +	Ma	Location *		
Category	Supplemental			GPS Latitude/Longitude		
				Start	End	
Item	DWR UCIP LMA Responsibility			38.129880 °	38.129880 °	
				-121.158017 °	-121.158017 °	
DWR ID	23784					
Comment Code						
Inspector Comment						
DS_ID:23784 FS_ID:38122 EP_NO: N/A Repair Type: No Action Needed EVAL Issue: Crossing Status: Found UCIP Comments: FIELD_STRUCT_DESC: 24-inch corrugated metal drainage pipe through the levee, 3 feet below the crown. Concrete U-shaped headwall on both ends. Flap gate on the waterside (WS) end. Cobble grouted spillway. Cobble grouted intake on the landside (LS). [Additional Reference(s): DWR Levee Log, 1990. USACE San Joaquin O&M Manual 612.2, 1967, (HLM 16.02)]. FS Date: 5/20/2014

Headwall on LS toe.

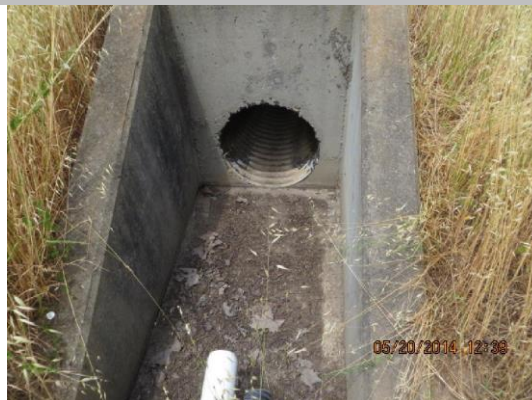
Photo 2 of 3 : UCIP_FA_2020_38122_69341.jpg

Headwall on LS toe.

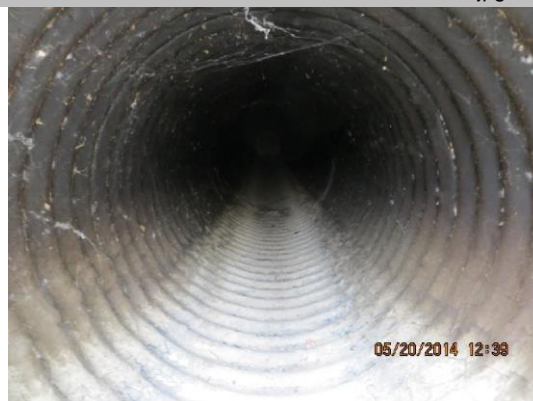
Photo 3 of 3 : UCIP_FA_2020_38122_69340.jpg

Inside pipe at LS toe.

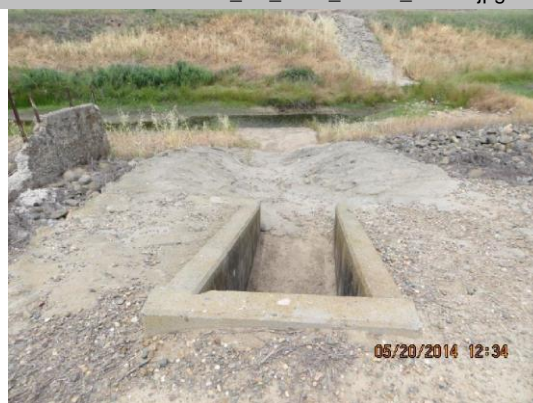
Photo 1 of 3 : UCIP_FA_2020_38121_69337.jpg

DS_ID:23785
 FS_ID:38121
 EP_NO: N/A
 Repair Type: No Action Needed
 EVAL Issue:
 Crossing Status: Found
 UCIP Comments:
 FIELD_STRUCT_DESC: 24-inch corrugated metal drainage pipe through the levee, 1.5 feet below the crown. Concrete U-shaped headwall on both ends. Flap gate on the waterside (WS) end. Cobble grouted spillway. Cobble grouted intake on the landside (LS).
 [Additional Reference(s): DWR Levee Log, 1990. USACE San Joaquin O&M Manual 612.2, 1967, (HLM 16.15)].
 FS Date: 5/20/2014

Headwall, flapgate, and grouted spillway on WS slope.

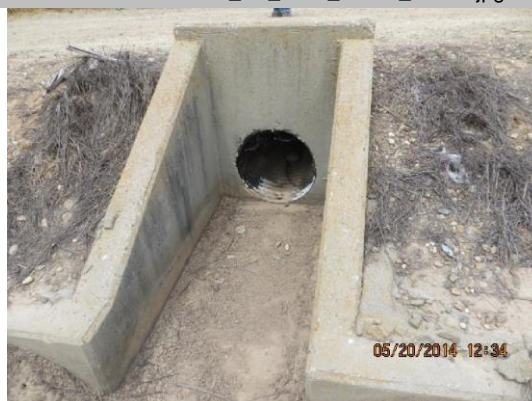
Photo 3 of 3 : UCIP_FA_2020_38121_69335.jpg

Headwall on LS toe.

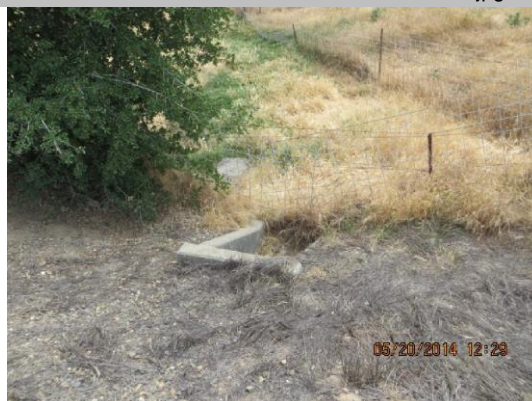
Photo 1 of 3 : UCIP_FA_2020_38120_69333.jpg

LM Start	15.82	Rating **	A/W	Issue No.	1206
LM End	15.82	Issue Type +	Ma	Location *	
Category	Supplemental			GPS Latitude/Longitude	
				Start	End
Item	DWR UCIP LMA Responsibility			38.130425 °	38.130425 °
				-121.154574 °	-121.154574 °
DWR ID	23786				
Comment Code					
Inspector Comment					
DS_ID:23786 FS_ID:38120 EP_NO: N/A Repair Type: No Action Needed EVAL Issue: Crossing Status: Found UCIP Comments: FIELD_STRUCT_DESC: 24-inch corrugated metal drainage pipe through the levee, 8 feet below the crown. Concrete U-shaped headwall on both ends. Flap gate on the waterside (WS) end. Cobble grouted spillway. Cobble grouted intake on the landside (LS). [Additional Reference(s): DWR Levee Log, 1990. USACE San Joaquin O&M Manual 612.2, 1967, (HLM 16.22)]. FS Date: 5/20/2014

Headwall at LS toe.

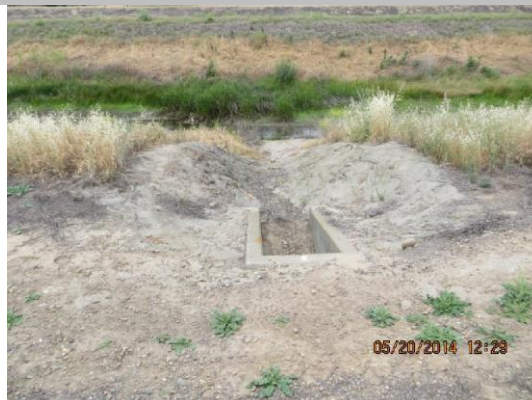
Photo 2 of 3 : UCIP_FA_2020_38120_69332.jpg

Headwall and flapgate at WS toe.

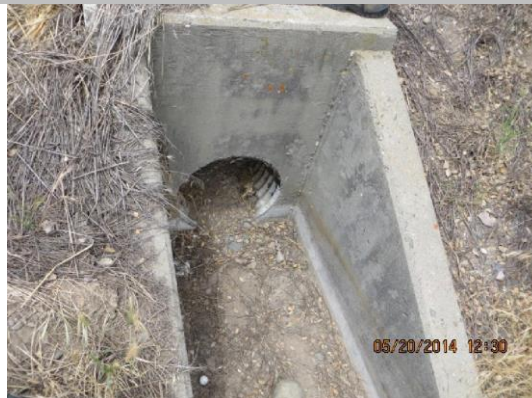
Photo 3 of 3 : UCIP_FA_2020_38120_69331.jpg

Headwall at LS toe.

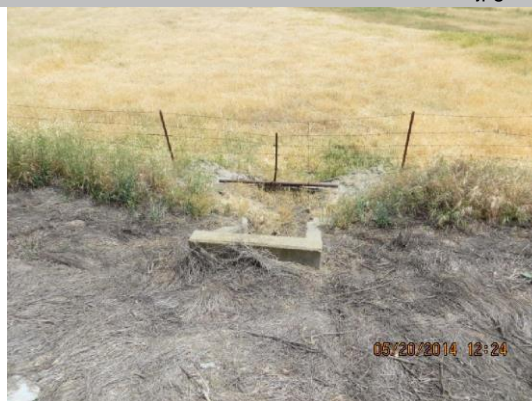
Photo 1 of 3 : UCIP_FA_2020_38119_69328.jpg

LM Start	15.88	Rating **	A/W	Issue No.	1207
LM End	15.88	Issue Type +	Ma	Location *	
Category	Supplemental			GPS Latitude/Longitude	
				Start	End
Item	DWR UCIP LMA Responsibility			38.131106 °	38.131106 °
				-121.153977 °	-121.153977 °
DWR ID	23787				
Comment Code					
Inspector Comment					
DS_ID:23787					
FS_ID:38119					
EP_NO: N/A					
Repair Type: No Action Needed					
EVAL Issue:					
Crossing Status: Found					
UCIP Comments:					
FIELD_STRUCT_DESC: 24-inch corrugated metal drainage pipe through the levee, 6 feet below the crown. Concrete U-shaped headwall on both ends. Flap gate on the waterside (WS) end. Cobble grouted spillway. Cobble grouted intake on the landside (LS). [Additional Reference(s): DWR Levee Log, 1990. USACE San Joaquin O&M Manual 612.2, 1967, (HLM 16.27)].					
FS Date: 5/20/2014

Concrete headwall on LS toe.

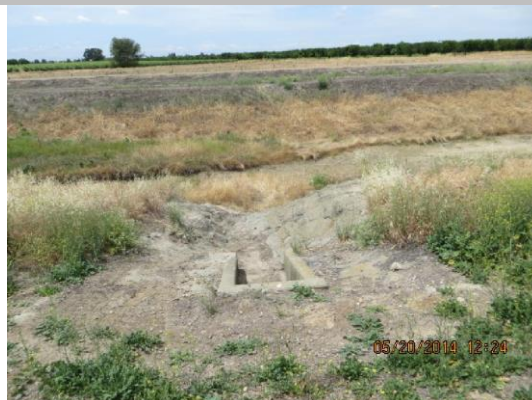
Photo 2 of 3 : UCIP_FA_2020_38119_69327.jpg

Flapgate and headwall on WS toe.

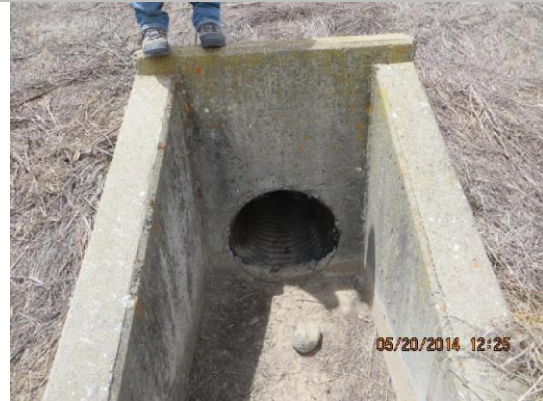
Photo 3 of 3 : UCIP_FA_2020_38119_69326.jpg

Concrete headwall on LS toe.

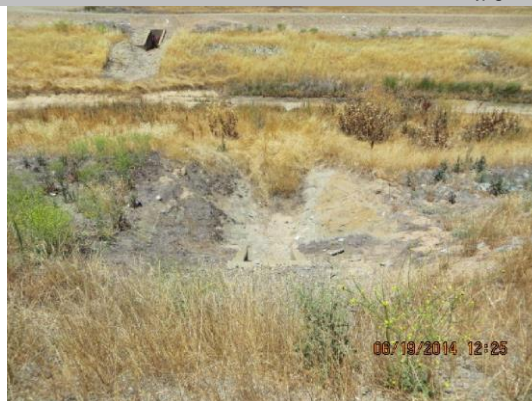
Photo 2 of 3 : UCIP_FA_2020_38975_71119.jpg

Pipe, flapgate, and grouted spillway on WS slope.

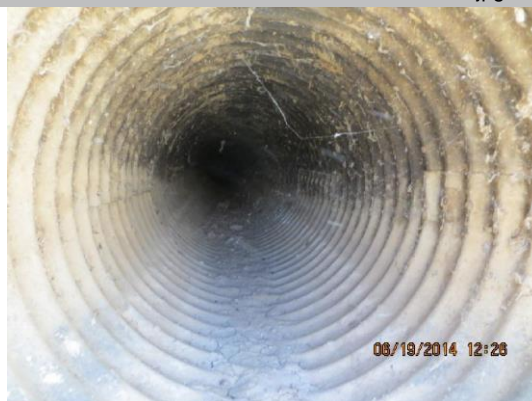
Photo 3 of 3 : UCIP_FA_2020_38975_71123.jpg

Inside pipe at LS toe.

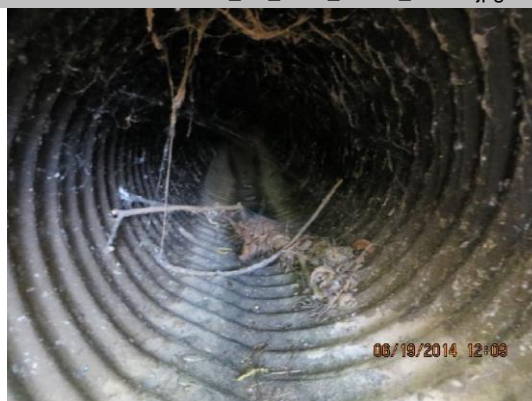
Photo 3 of 3 : UCIP_FA_2020_38973_71108.jpg

Inside pipe at LS toe.

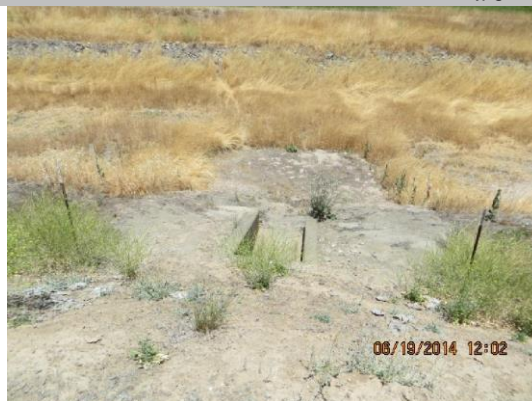
Photo 2 of 3 : UCIP_FA_2020_38972_71104.jpg

Pipe, flapgate, and grouted spillway on WS slope.

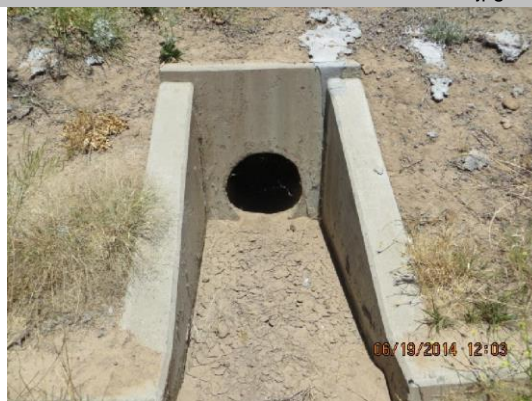
Photo 3 of 3 : UCIP_FA_2020_38972_71103.jpg

Pipe and headwall on LS toe.

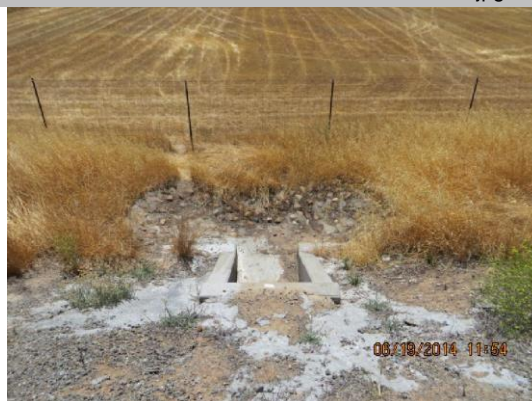
Photo 1 of 3 : UCIP_FA_2020_38971_71100.jpg

Pipe and headwall on LS toe.

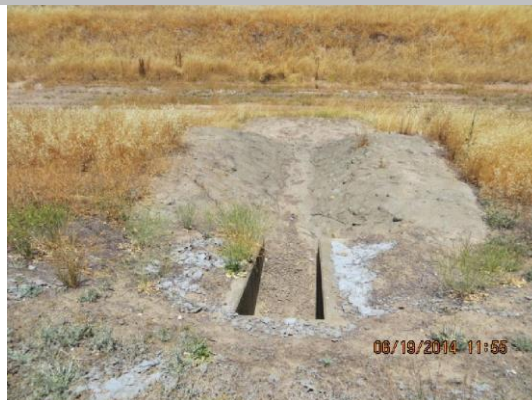
Photo 2 of 3 : UCIP_FA_2020_38971_71099.jpg

Pipe, flapgate, and grouted spillway on WS slope.

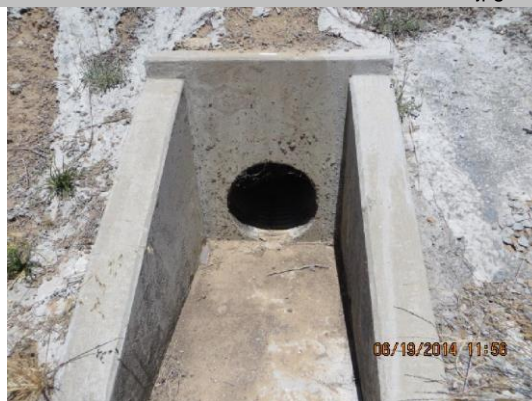
Photo 3 of 3 : UCIP_FA_2020_38971_71098.jpg

Pipe and headwall on LS toe.

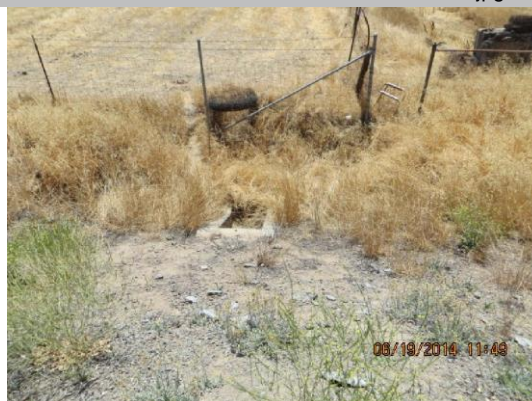
Photo 1 of 3 : UCIP_FA_2020_41812_71095.jpg

DS_ID:23841
 FS_ID:41812
 EP_NO: N/A
 Repair Type: Non-Urgent
 EVAL Issue:
 Crossing Status: Found
 UCIP Comments: Sediment buildup inside pipe.
 FIELD_STRUCT_DESC: 12-inch corrugated metal storm drainage pipe through the levee, 7 feet below the crown. Headwall on the landside (LS) toe. Flap gate on the waterside (WS) end. Cobble grouted spillway. [Additional Reference(s): DWR Levee Log, 1987. USACE San Joaquin O&M Manual 612 (addendum), February 1999, (HLM 0.93) (Station 49+30)].
 FS Date: 6/19/2014

Pipe and headwall on LS toe.

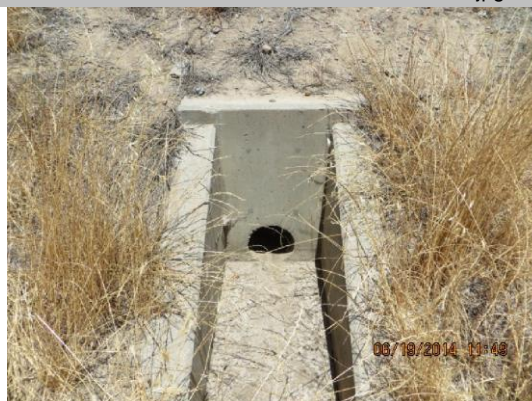
Photo 2 of 3 : UCIP_FA_2020_41812_71094.jpg

Pipe and headwall on LS toe.

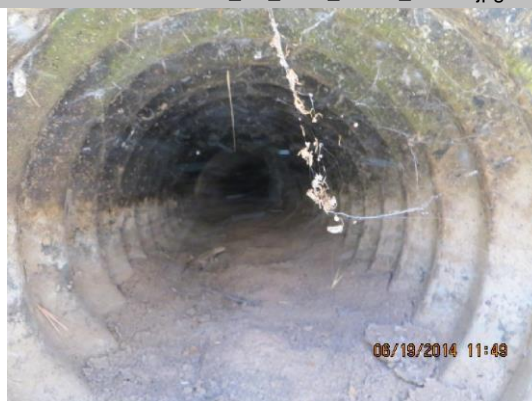
Photo 3 of 3 : UCIP_FA_2020_41812_71093.jpg

Inside pipe at LS toe.

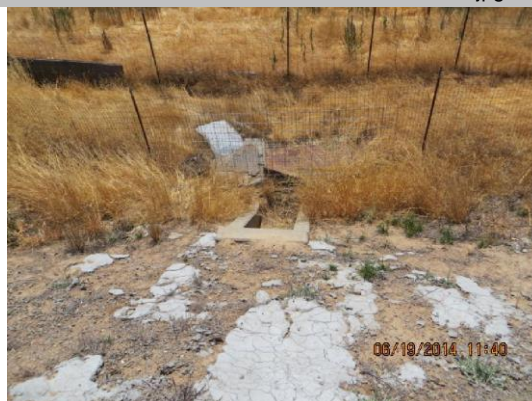
Photo 1 of 3 : UCIP_FA_2020_38969_71090.jpg

Pipe and headwall on LS toe.

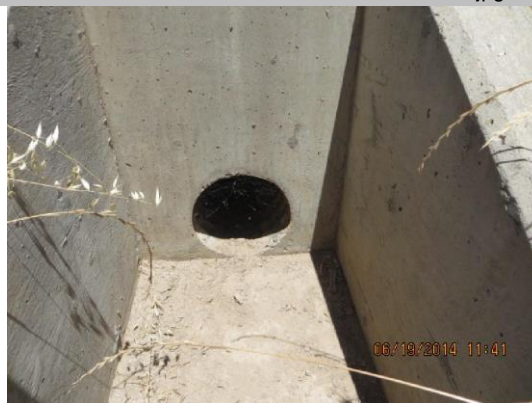
Photo 2 of 3 : UCIP_FA_2020_38969_71089.jpg

Pipe and headwall on LS toe.

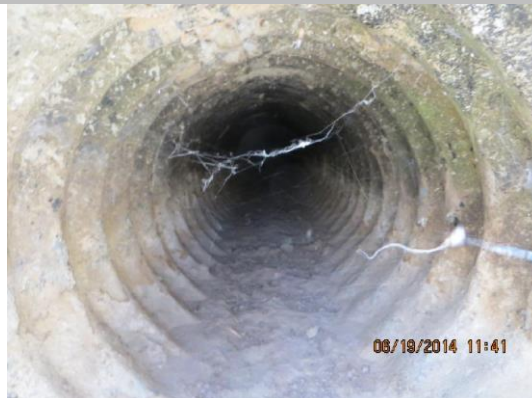
Photo 3 of 3 : UCIP_FA_2020_38969_71088.jpg

Inside pipe at LS toe.

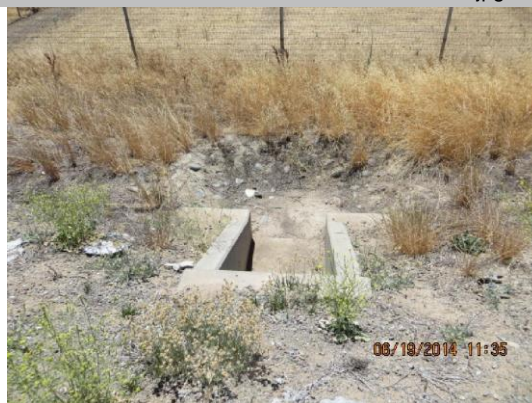
Photo 1 of 3 : UCIP_FA_2020_38968_71085.jpg

Headwall at LS toe.

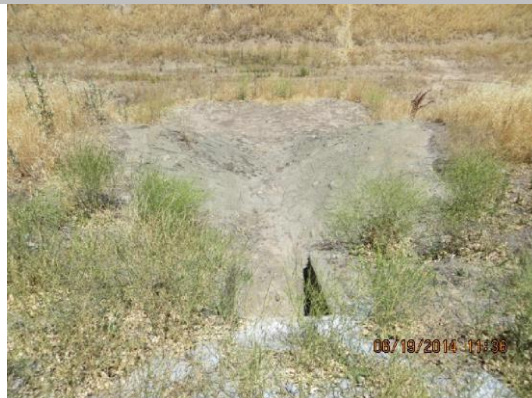
Photo 2 of 3 : UCIP_FA_2020_38968_71084.jpg

Pipe, flapgate, and grouted spillway on WS toe.

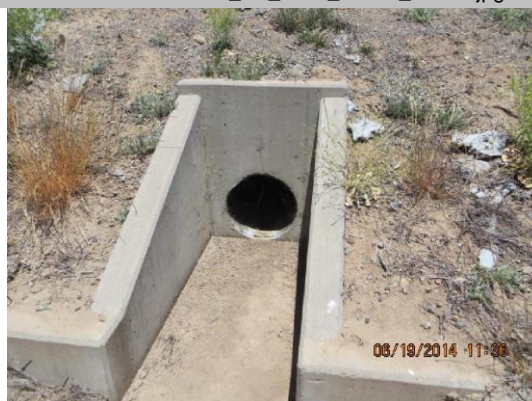
Photo 3 of 3 : UCIP_FA_2020_38968_71083.jpg

Headwall at LS toe.

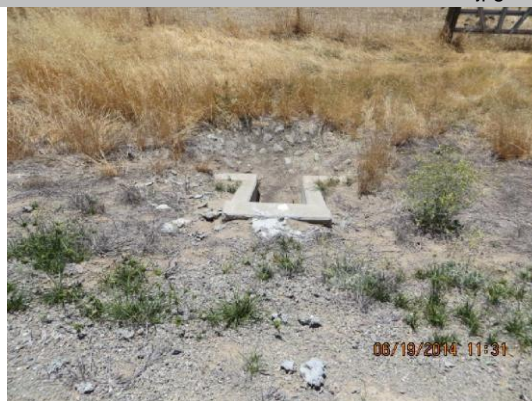
Photo 1 of 3 : UCIP_FA_2020_38967_71079.jpg

Pipe and headwall on LS toe.

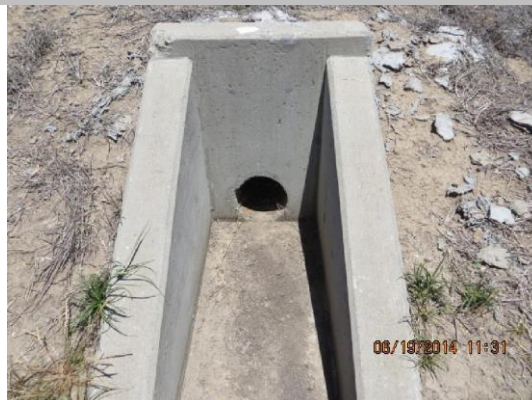
Photo 2 of 3 : UCIP_FA_2020_38967_71078.jpg

Pipe and headwall on LS toe.

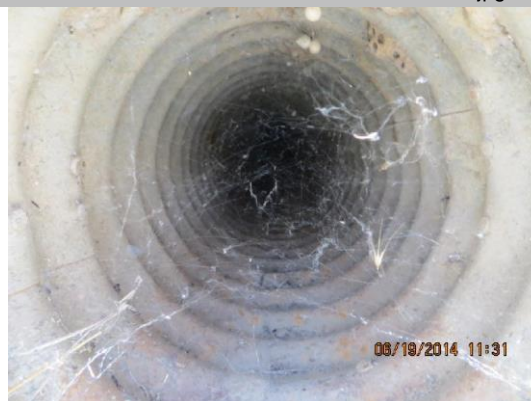
Photo 3 of 3 : UCIP_FA_2020_38967_71082.jpg

Inside pipe at LS toe.

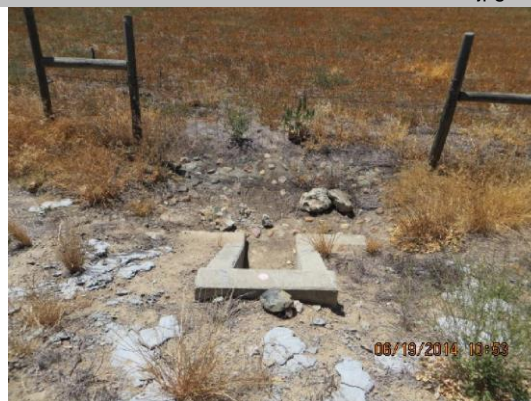
Photo 1 of 3 : UCIP_FA_2020_38997_71074.jpg

Headwall at LS toe.

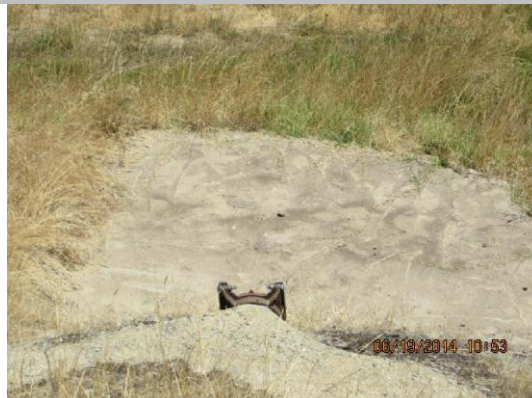
Photo 2 of 3 : UCIP_FA_2020_38997_71073.jpg

Pipe, flapgate, and grouted spillway on WS toe.

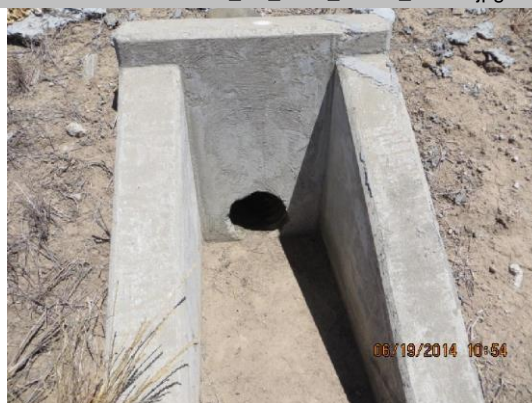
Photo 3 of 3 : UCIP_FA_2020_38997_71077.jpg

Headwall on LS toe.

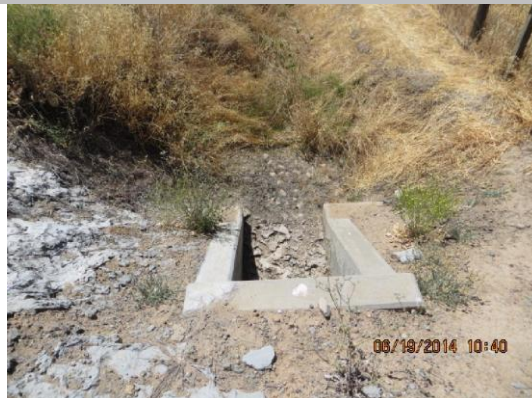
Photo 1 of 3 : UCIP_FA_2020_38977_71064.jpg

Concrete headwall on LS toe.

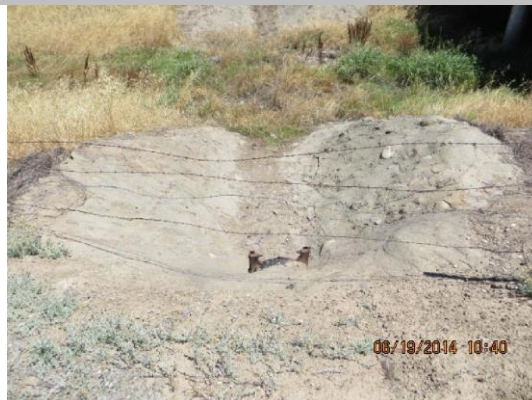
Photo 2 of 3 : UCIP_FA_2020_38977_71063.jpg

Pipe, flapgate, and grouted spillway on WS toe.

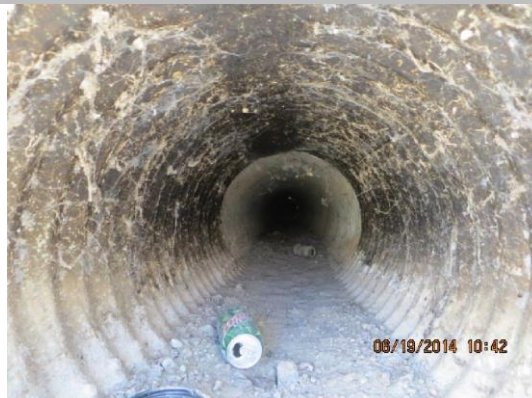
Photo 3 of 3 : UCIP_FA_2020_38977_71067.jpg

Inside pipe at LS toe.

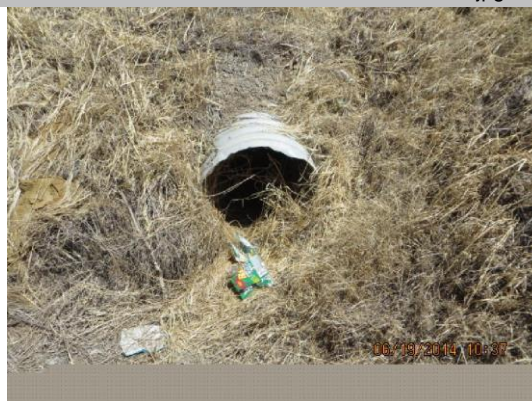
Photo 2 of 3 : UCIP_FA_2020_38963_70883.jpg

Pipe visible on LS toe.

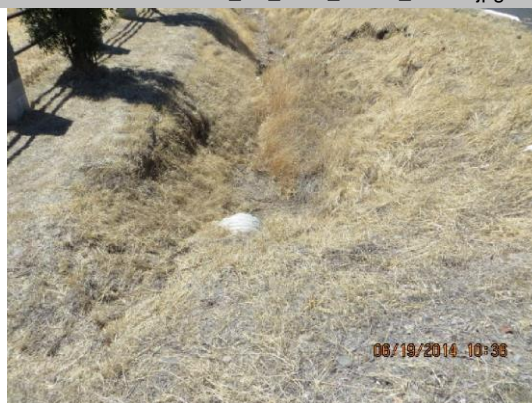
Photo 3 of 3 : UCIP_FA_2020_38963_71060.jpg

Pipe visible on LS toe.

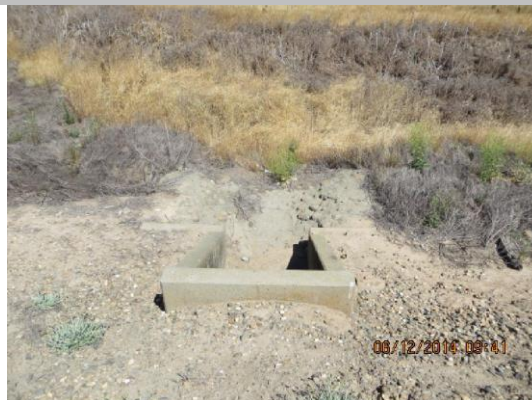
Photo 2 of 3 : UCIP_FA_2020_38567_70660.jpg

Headwall at LS toe.

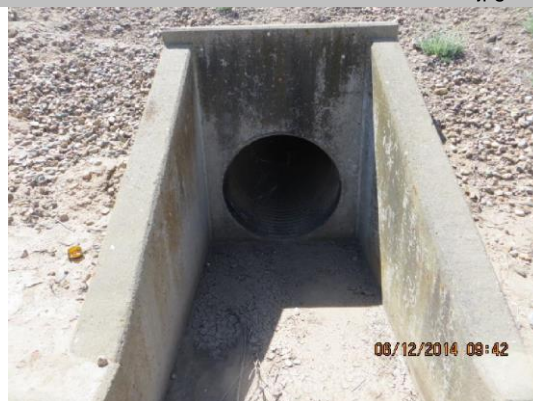
Photo 3 of 3 : UCIP_FA_2020_38567_70659.jpg

Headwall at LS toe.

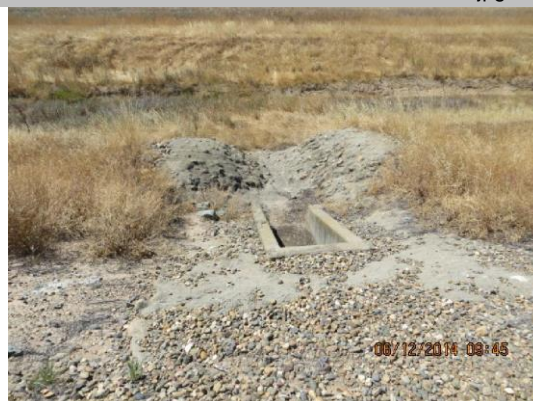
Photo 1 of 3 : UCIP_FA_2020_38568_70666.jpg

DS_ID:23860
 FS_ID:38568
 EP_NO: N/A
 Repair Type: No Action Needed
 EVAL Issue:
 Crossing Status: Found
 UCIP Comments:
 FIELD_STRUCT_DESC: 24-inch corrugated metal drainage pipe through the levee, 7 feet below the crown. Concrete U-shaped headwall on both ends. Flap gate on the waterside (WS) end. Cobble grouted spillway. Cobble grouted intake on the landside (LS). [Additional Reference(s): DWR Levee Log, 1978. USACE San Joaquin O&M Manual 612.2, 1967, (HLM 0.24)].
 FS Date: 6/12/2014

Headwall, flapgate, and grouted spillway on WS slope.

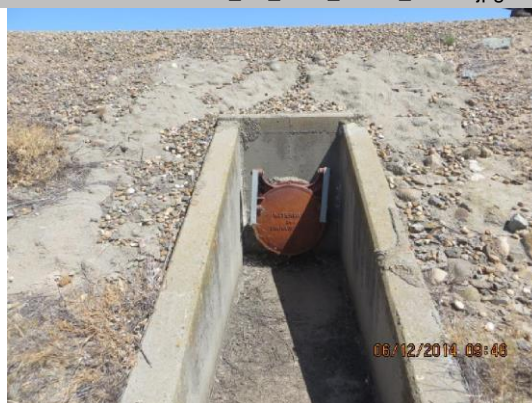
Photo 3 of 3 : UCIP_FA_2020_38568_70664.jpg

Headwall and flapgate on WS slope.

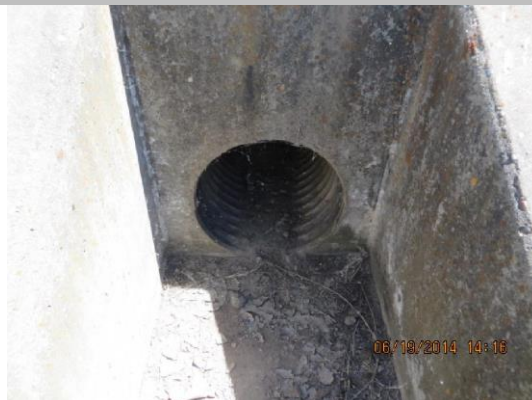
Photo 2 of 3 : UCIP_FA_2020_38994_71164.jpg

Pipe and headwall on LS toe.

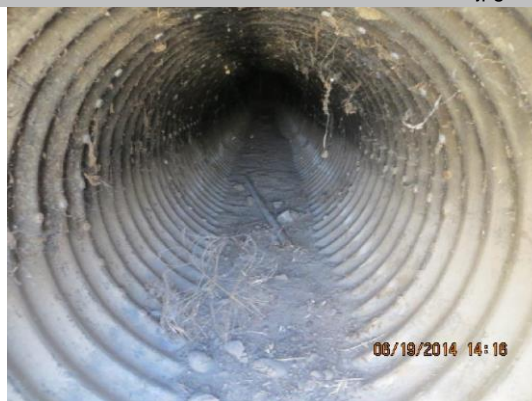
Photo 3 of 3 : UCIP_FA_2020_38994_71163.jpg

Inside pipe at LS toe.

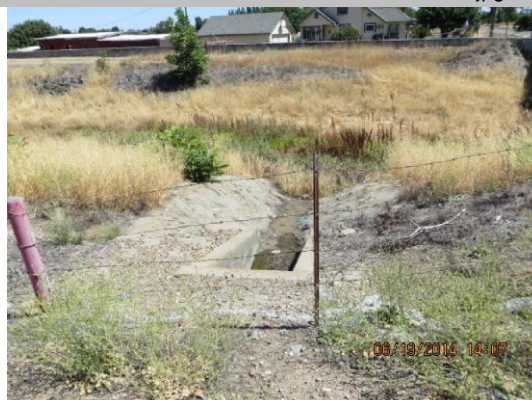
Photo 2 of 3 : UCIP_FA_2020_38992_71157.jpg

Pipe, headwall, flapgate, and grouted spillway on WS toe.

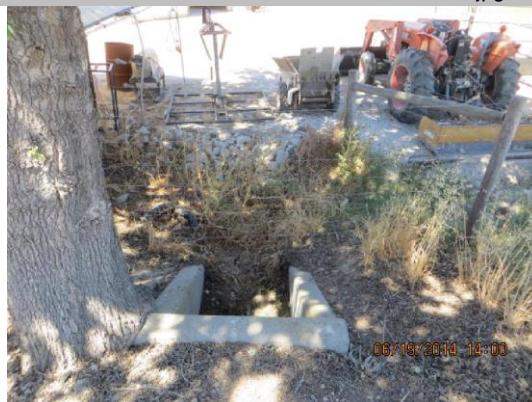
Photo 2 of 3 : UCIP_FA_2020_38990_71152.jpg

Pipe and headwall on LS toe.
