**Flood Control Project Maintenance
Levee Inspections**

Maintenance Issue Types Only, Levee Inspection Report By Mile - Fall 2020

San Joaquin County Flood Control and Water Conservation District

Waterway	Bank	Unit Miles	Inspection Start/End	Inspector
Unit No. 01 Littlejohn Creek	Left	2.59	10/20/2020 10/20/2020	Alberto De Leon

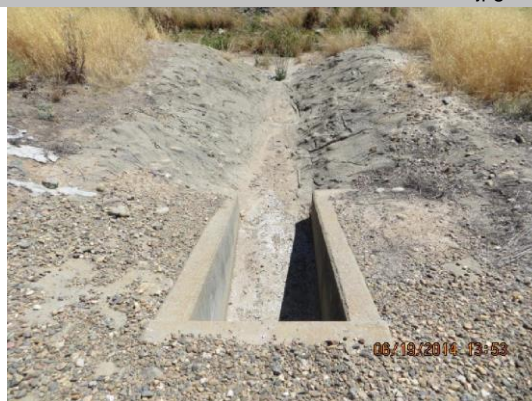
Photo 1 of 3 : UCIP_FA_2020_38989_71148.jpg

LM Start	0.86	Rating **	A/W	Issue No.	29
LM End	0.86	Issue Type +	Ma	Location *	
Category	Supplemental			GPS Latitude/Longitude	
				Start	End
Item	DWR UCIP LMA Responsibility			38.094639 °	38.094639 °
				-121.159426 °	-121.159426 °
DWR ID	23865				
Comment Code					
Inspector Comment					
DS_ID:23865 FS_ID:38989 EP_NO: N/A Repair Type: No Action Needed EVAL Issue: Crossing Status: Found UCIP Comments: FIELD_STRUCT_DESC: 24-inch corrugated metal drainage pipe through the levee, 5.5 feet below the crown. Concrete U-shaped headwall on both ends. Flap gate on the waterside (WS) end. Cobble grouted spillway. Cobble grouted intake on the landside (LS). [Additional Reference(s): DWR Levee Log, 1978. USACE San Joaquin O&M Manual 612.2, 1967, (HLM 0.86)]. FS Date: 6/19/2014

Pipe, headwall, flapgate, and grouted spillway on WS toe.

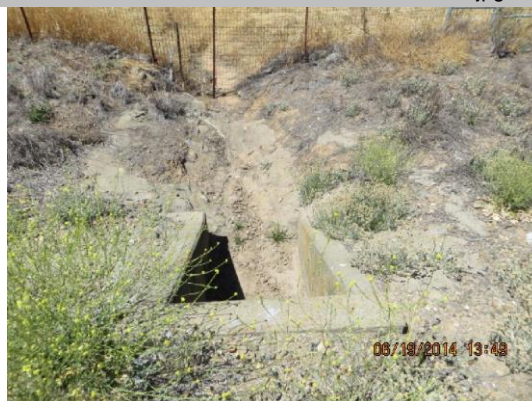
Photo 1 of 3 : UCIP_FA_2020_38988_71144.jpg

DS_ID:23866
 FS_ID:38988
 EP_NO: N/A
 Repair Type: No Action Needed
 EVAL Issue:
 Crossing Status: Found
 UCIP Comments:
 FIELD_STRUCT_DESC: 24-inch corrugated metal drainage pipe through the levee, 5 feet below the crown. Concrete U-shaped headwall on both ends. Flap gate on the waterside (WS) end. Cobble grouted spillway. Cobble grouted intake on the landside (LS). [Additional Reference(s): DWR Levee Log, 1978. USACE San Joaquin O&M Manual 612.2, 1967, (HLM 1.09)].
 FS Date: 6/19/2014

Pipe and headwall on LS toe.

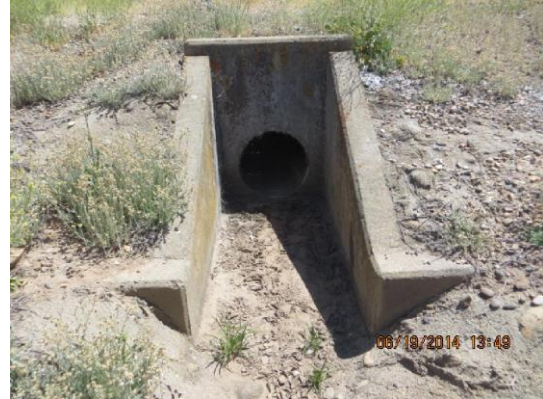
Photo 2 of 3 : UCIP_FA_2020_38988_71143.jpg

Pipe and headwall on LS toe.

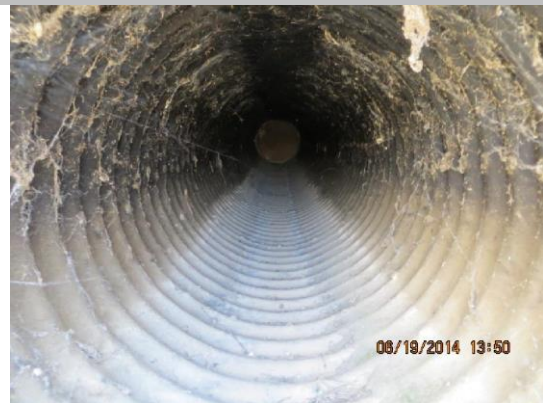
Photo 3 of 3 : UCIP_FA_2020_38988_71142.jpg

Inside pipe at LS toe.

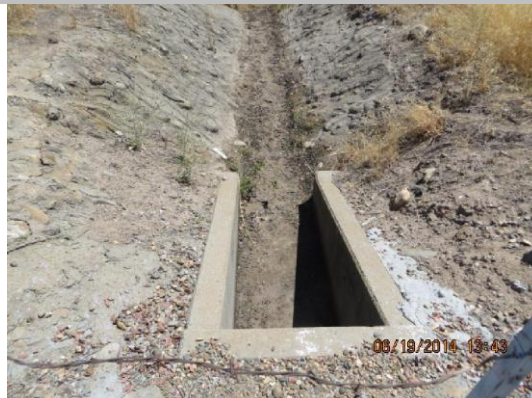
Photo 1 of 3 : UCIP_FA_2020_38987_71139.jpg

LM Start	1.32	Rating **	A/W	Issue No.	31
LM End	1.32	Issue Type +	Ma	Location *	
Category	Supplemental			GPS Latitude/Longitude	
				Start	End
Item	DWR UCIP LMA Responsibility			38.094351 °	38.094351 °
				-121.150962 °	-121.150962 °
DWR ID	23867				
Comment Code					
Inspector Comment					
DS_ID:23867 FS_ID:38987 EP_NO: N/A Repair Type: No Action Needed EVAL Issue: Crossing Status: Found UCIP Comments: FIELD_STRUCT_DESC: 24-inch corrugated metal drainage pipe through the levee, 4 feet below the crown. Concrete U-shaped headwall on both ends. Flap gate on the waterside (WS) end. Cobble grouted spillway. Cobble grouted intake on the landside (LS). [Additional Reference(s): DWR Levee Log, 1978. USACE San Joaquin O&M Manual 612.2, 1967, (HLM 1.33)]. FS Date: 6/19/2014

Pipe, headwall, flapgate, and grouted spillway on WS toe.

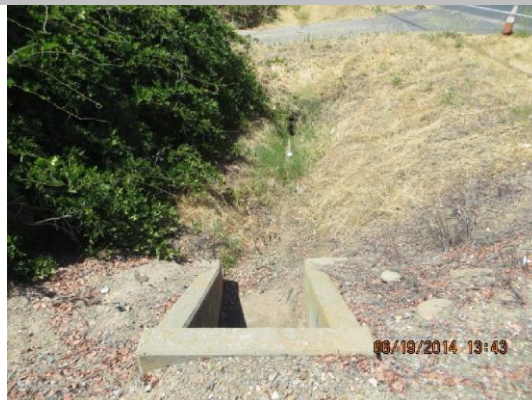
Photo 2 of 3 : UCIP_FA_2020_38987_71138.jpg

Pipe and headwall on LS toe.

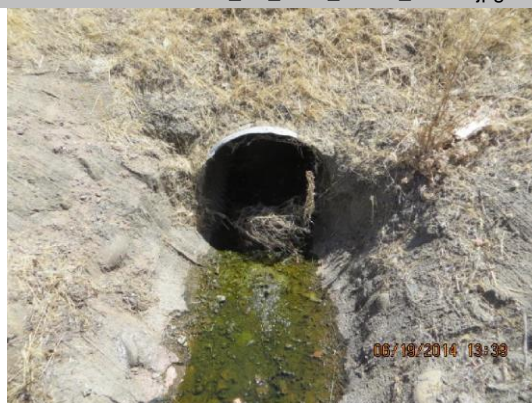
Photo 3 of 3 : UCIP_FA_2020_51721_71132.jpg

Pipe on LS toe.

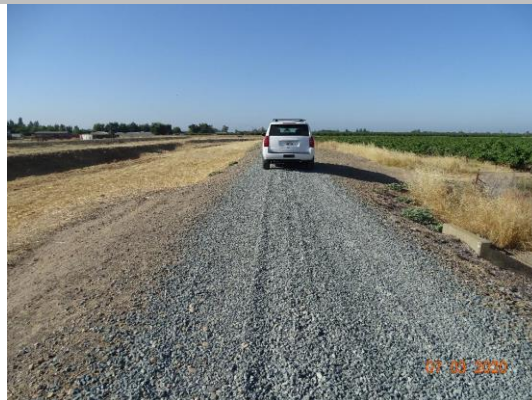
Photo 1 of 3 : UCIP_FA_2020_59640_86887.jpg

Comment Code						
Inspector Comment						
DS_ID:23880 FS_ID:59640 EP_NO: N/A Repair Type: Non-Urgent EVAL Issue: Unauthorized Encroachment, installed decades prior Crossing Status: Found UCIP Comments: 07/03/2020 Crossing evaluated as "Non-Urgent" because there was no permit found authorizing this pipe. (A. McDonald - DWR UCIP) FIELD_STRUCT_DESC: 24-inch corrugated metal drainage pipe through the levee, 5 feet below the crown. Concrete U-shaped headwall on both ends. Flap gate on the waterside (WS) end. Cobble grouted spillway. Cobble grouted intake on the landside (LS). [Additional Reference(s): DWR Levee Log, 1978. USACE San Joaquin O&M Manual 612.2, 1967, (HLM 0.16)]. FS Date: 7/3/2020

Overview of levee crown looking d/s.

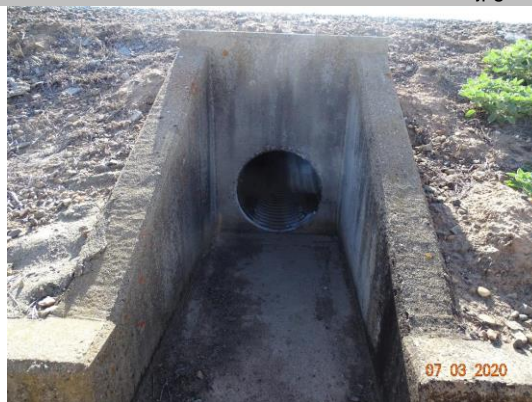
Photo 2 of 3 : UCIP_FA_2020_59640_86888.jpg

Pipe inlet and headwall at LS levee toe.

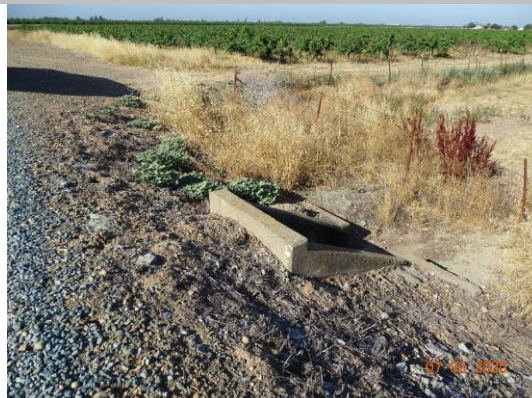
Photo 3 of 3 : UCIP_FA_2020_59640_86889.jpg

Pipe inlet, headwall, and flap gate at LS levee toe.

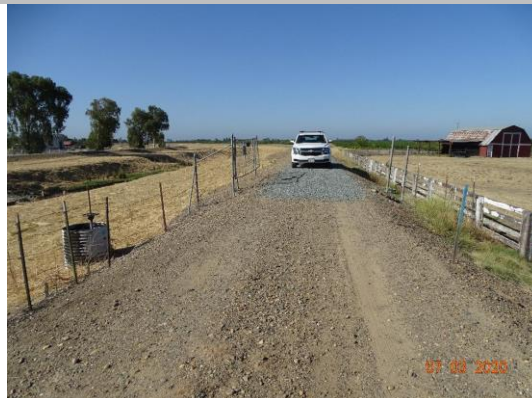
Photo 1 of 3 : UCIP_FA_2020_59641_86893.jpg

Comment Code						
Inspector Comment						
DS_ID:23881 FS_ID:59641 EP_NO: N/A Repair Type: Non-Urgent EVAL Issue: Crossing Status: Found UCIP Comments: 07/03/2020 Crossing evaluated as "Non-Urgent" because there was no permit found authorizing this pipe. (A. McDonald - DWR UCIP) Slide gate does not function properly up or down. FIELD_STRUCT_DESC: 24-inch corrugated metal drainage pipe through the levee, 11 feet below the crown. Slide gate in 36-inch corrugated metal riser unit on the waterside (WS). Concrete U-shaped headwall on the WS end. Cobble grouted spillway. Cobble grouted intake on the landside (LS). [Additional Reference(s): DWR Levee Log, 1978. USACE San Joaquin O&M Manual 612.2, 1967, (HLM 0.47)]. FS Date: 7/3/2020

Overview of levee crown looking d/s.

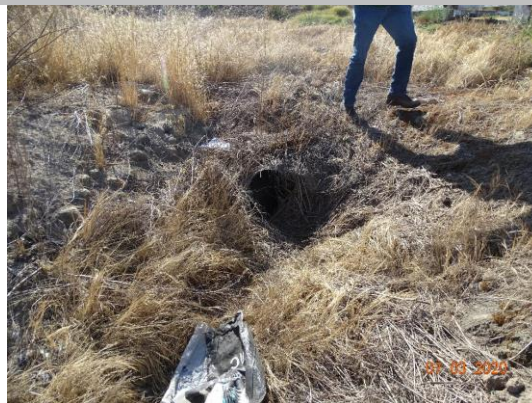
Photo 2 of 3 : UCIP_FA_2020_59641_86894.jpg

Pipe inlet at the LS levee toe. No headwall.

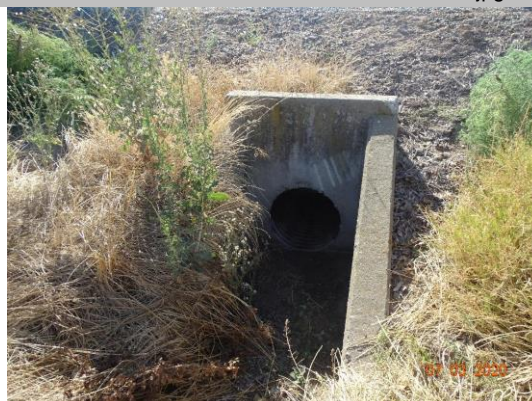
Photo 2 of 3 : UCIP_FA_2020_59642_86907.jpg

Pipe inlet and headwall at the LS levee toe.

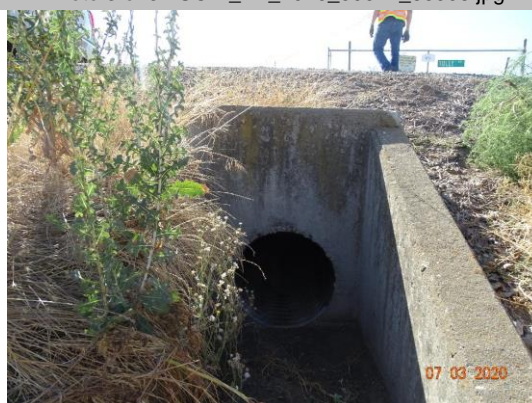
Photo 3 of 3 : UCIP_FA_2020_59642_86908.jpg

Pipe inlet and headwall at the LS levee toe.

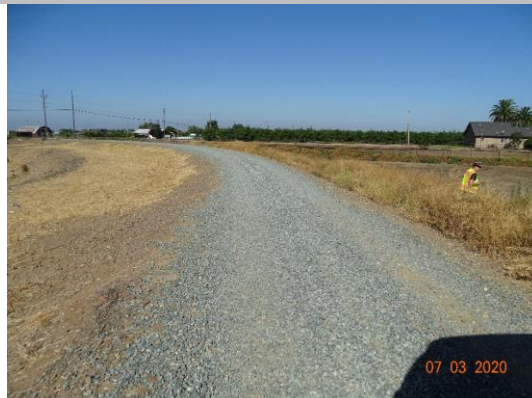
Photo 1 of 3 : UCIP_FA_2020_59643_86911.jpg

Comment Code						
Inspector Comment						
DS_ID:23883 FS_ID:59643 EP_NO: N/A Repair Type: Non-Urgent EVAL Issue: Unauthorized Encroachment, installed decades prior Crossing Status: Found UCIP Comments: 07/03/2020 Crossing evaluated as "Non-Urgent" because there was no permit found authorizing this pipe. Video inspection performed on 02-21-2020. (A. McDonald - DWR UCIP)Pipe filled in with soil on the LS toe and appears to be temporarily abandoned. FIELD_STRUCT_DESC: 24-inch corrugated metal drainage pipe through the levee, 6.5 feet below the crown. Concrete U-shaped headwall on both ends. Flap gate on the waterside (WS) end. Cobble grouted spillway. Cobble grouted intake on the landside (LS). [Additional Reference(s): DWR Levee Log, 1978. USACE San Joaquin O&M Manual 612.2, 1967, (HLM 0.55)]. FS Date: 7/3/2020

Overview of levee crown looking d/s.

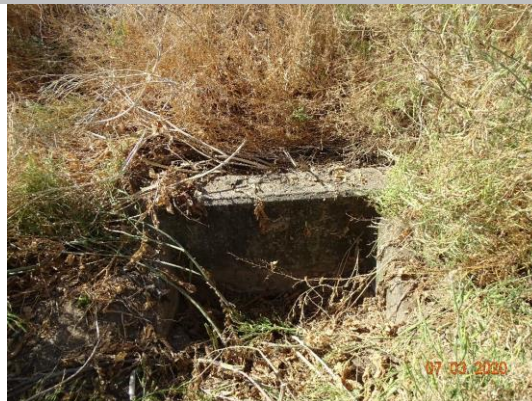
Photo 2 of 3 : UCIP_FA_2020_59643_86912.jpg

Pipe inlet and headwall at the LS levee toe.

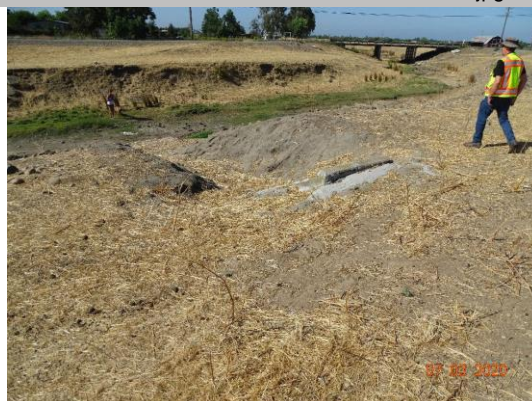
Photo 3 of 3 : UCIP_FA_2020_59643_86913.jpg

Pipe outlet, headwall, and flap gate at the WS levee toe.

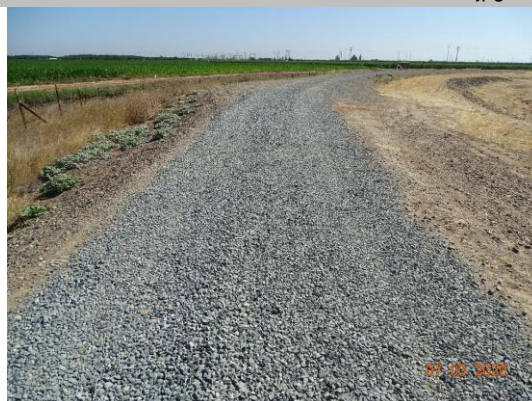
Photo 1 of 3 : UCIP_FA_2020_59645_86934.jpg

Comment Code						
Inspector Comment						
DS_ID:23885 FS_ID:59645 EP_NO: N/A Repair Type: Non-Urgent EVAL Issue: Unauthorized Encroachment, installed decades prior Crossing Status: Found UCIP Comments: 07/03/2020 Crossing evaluated as "Non-Urgent" because there was no permit found authorizing this pipe. Video inspection performed on 04-24-2020. (A. McDonald - DWR UCIP) FIELD_STRUCT_DESC: 24-inch corrugated metal drainage pipe through the levee, 6 feet below the crown. Concrete U-shaped headwall on both ends. Flap gate on the waterside (WS) end. Slide gate on the landside (LS) end. Cobble grouted spillway. Cobble grouted intake on the LS. [Additional Reference(s): DWR Levee Log, 1978. USACE San Joaquin O&M Manual 612.2, 1967, (HLM 1.07)]. FS Date: 7/3/2020

Overview of levee crown looking d/s.

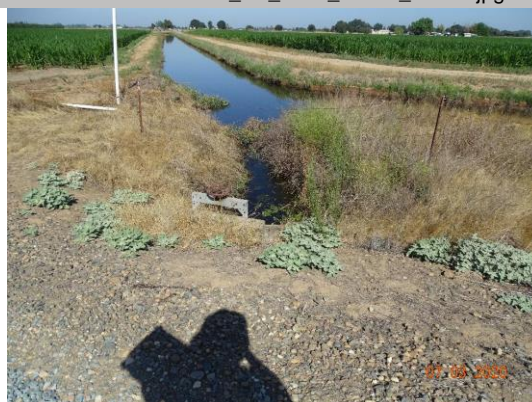
Photo 2 of 3 : UCIP_FA_2020_59645_86930.jpg

View of pipe inlet, headwall, and slide gate at the LS levee toe.

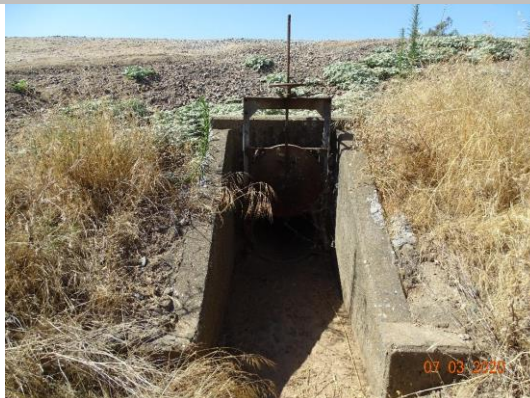
Photo 2 of 3 : UCIP_FA_2020_59646_86937.jpg

Pipe inlet, headwall, and slide gate at the LS levee toe.

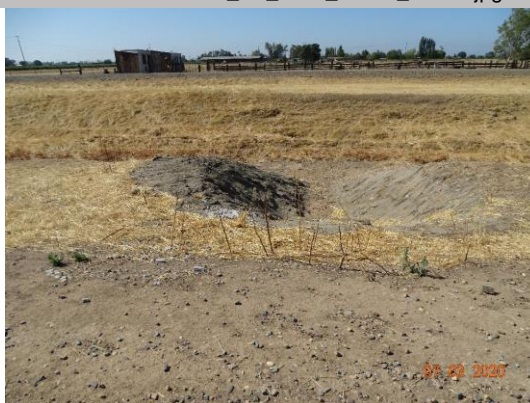
Photo 3 of 3 : UCIP_FA_2020_59646_86938.jpg

View of WS channel looking from the levee crown.

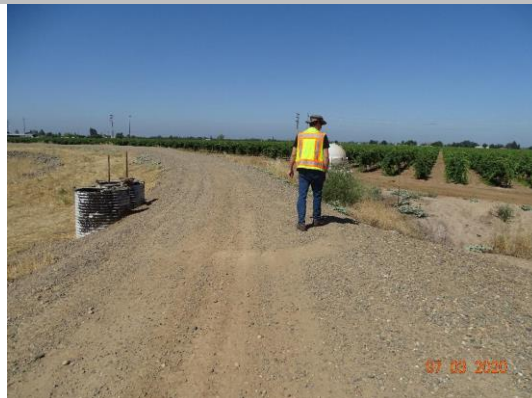
Photo 1 of 3 : UCIP_FA_2020_59647_86960.jpg

Comment Code						
Inspector Comment						
DS_ID:23871						
FS_ID:59647						
EP_NO: N/A						
Repair Type: Non-Urgent						
EVAL Issue: Unauthorized Encroachment, installed decades prior						
Crossing Status: Found						
UCIP Comments: 07/03/2020 Crossing evaluated as "Non-Urgent"						
because there was no permit found authorizing this pipe. (A.						
McDonald - DWR UCIP) Slide gate may be rusted shut or does not						
function. Heavy sediment buildup in pipe. Lid on CMP riser needs						
repair.						
FIELD_STRUCT_DESC: 1 of 2: 36-inch corrugated metal drainage pipe						
through the levee, 7 feet below the crown. Slide gate in 48-inch						
corrugated metal riser unit on the waterside (WS) slope. Concrete U-						
shaped headwall on both ends. Flap gate on the WS end. Cobble						
grouted spillway. Cobble grouted intake on the landside (LS).						
[Additional Reference(s): DWR Levee Log, 1978. USACE San Joaquin

Overview of levee crown looking d/s.

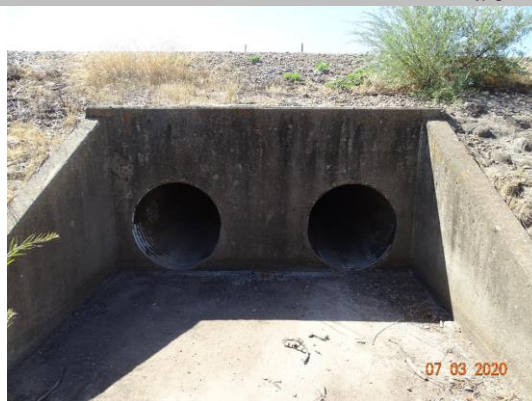
Photo 2 of 3 : UCIP_FA_2020_59647_86961.jpg

Two pipe inlets and headwall at the LS levee toe.

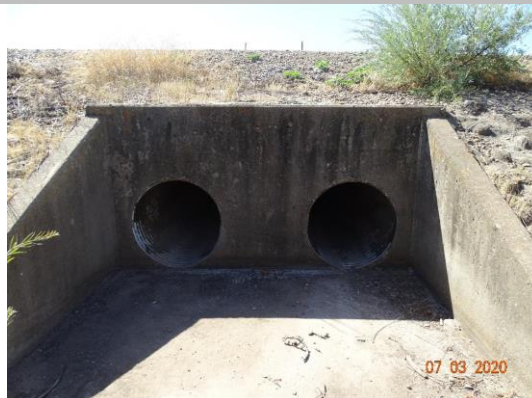
Photo 2 of 3 : UCIP_FA_2020_59648_86966.jpg

Two pipe inlets and headwall at the LS levee toe.

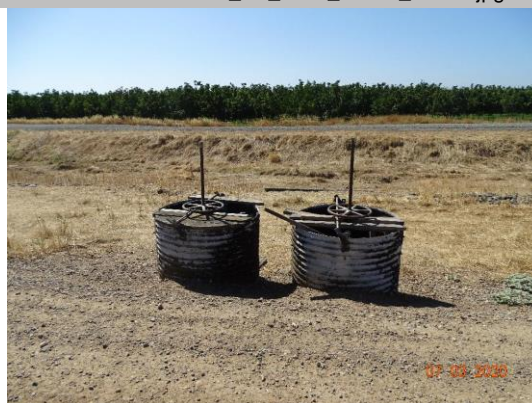
Photo 3 of 3 : UCIP_FA_2020_59648_86967.jpg

Two risers and slide gates on the WS levee slope.

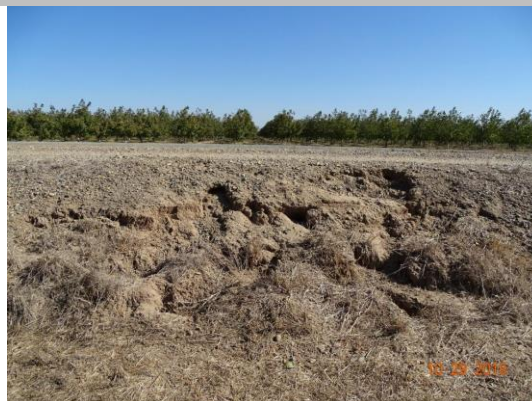
Photo 1 of 1 : FA_2020_NA0017_155_42_20200901_00009.jpg

LM Start	1.58	Rating **	U	Issue No.	42
LM End	1.60	Issue Type +	Ma	Location *	LS
Category	Earthen Levee			GPS Latitude/Longitude	
				Start	End
Item	Animal Control			38.112401 °	38.112702 °
				-121.158875 °	-121.158873 °
DWR ID	DWR_NA0017_11_f_2019_42				
Comment Code					
A3 : No rodents visible, but rodent burrows visible; need to backfill and compact or grout burrows.					
Inspector Comment

View of multiple animal burrows on landside slope. Fall 2019

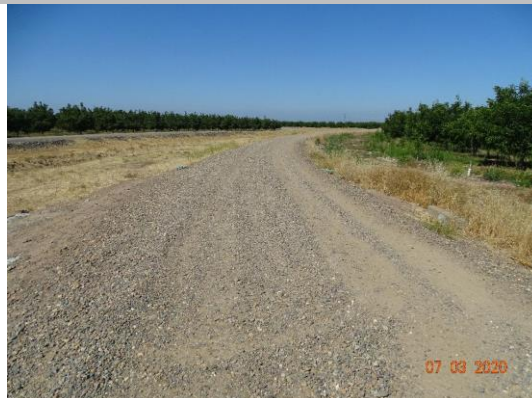
Photo 1 of 3 : UCIP_FA_2020_59649_86978.jpg

Comment Code						
Inspector Comment						
DS_ID:23872 FS_ID:59649 EP_NO: N/A Repair Type: Non-Urgent EVAL Issue: Unauthorized Encroachment, installed decades prior Crossing Status: Found UCIP Comments: 07/03/2020 Crossing evaluated as "Non-Urgent" because there was no permit found authorizing this pipe. (A. McDonald - DWR UCIP) FIELD_STRUCT_DESC: 24-inch corrugated metal drainage pipe through the levee, 5.5 feet below the crown. Concrete U-shaped headwall on both ends. Flap gate on the waterside (WS) end. Cobble grouted spillway. Cobble grouted intake on the landside (LS). [Additional Reference(s): DWR Levee Log, 1978. USACE San Joaquin O&M Manual 612.2, 1967, (HLM 1.82)]. FS Date: 7/3/2020

Overview of levee crown looking d/s.

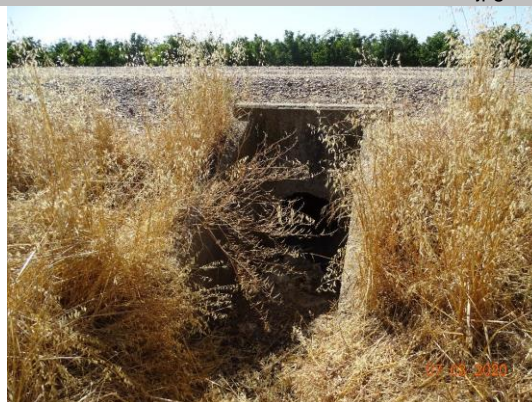
Photo 2 of 3 : UCIP_FA_2020_59649_86979.jpg

Pipe inlet and headwall located at the LS levee toe.

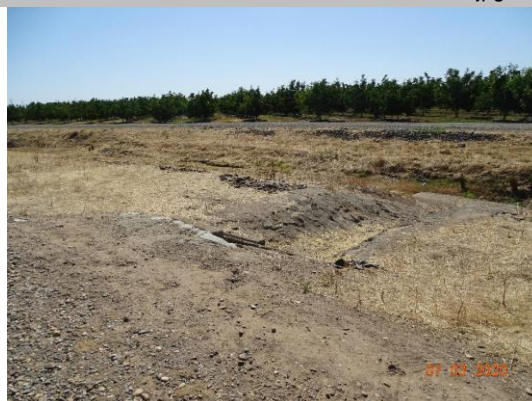
Photo 3 of 3 : UCIP_FA_2020_59649_86980.jpg

Overview of WS channel looking from the levee crown.

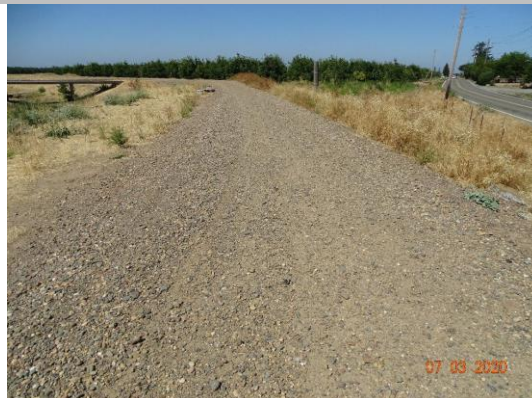
Photo 1 of 3 : UCIP_FA_2020_59651_86988.jpg

Comment Code						
Inspector Comment						
DS_ID:23874 FS_ID:59651 EP_NO: N/A Repair Type: Non-Urgent EVAL Issue: Unauthorized Encroachment, installed decades prior Crossing Status: Found UCIP Comments: 07/03/2020 Crossing evaluated as "Non-Urgent" because there was no permit found authorizing this pipe. (A. McDonald - DWR UCIP) FIELD_STRUCT_DESC: 24-inch corrugated metal drainage pipe through the levee, 6 feet below the crown. Concrete U-shaped headwall on both ends. Flap gate on the waterside (WS) end. Cobble grouted spillway. Cobble grouted intake on the landside (LS). [Additional Reference(s): DWR Levee Log, 1978. USACE San Joaquin O&M Manual 612.2, 1967, (HLM 2.05)]. FS Date: 7/3/2020

Overview of levee crown looking d/s.

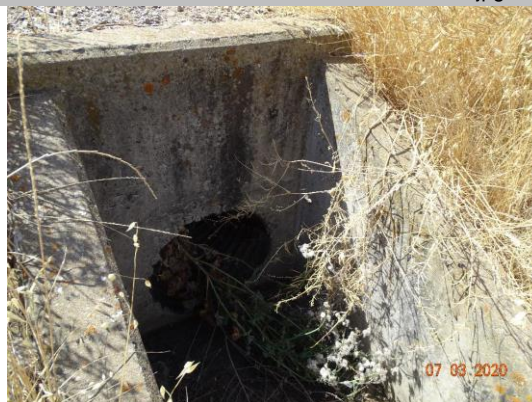
Photo 2 of 3 : UCIP_FA_2020_59651_86989.jpg

Inlet pipe and headwall located at the LS levee toe.

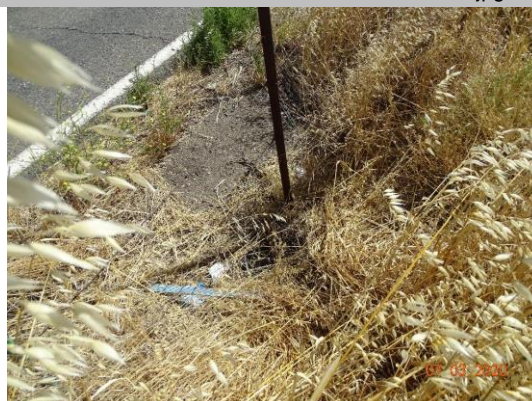
Photo 2 of 3 : UCIP_FA_2020_59652_86992.jpg

View of pipe inlet at the LS levee toe.

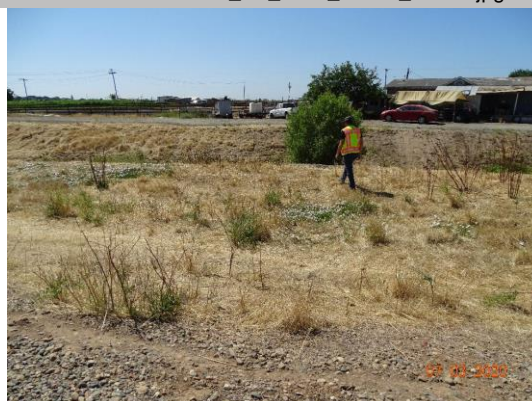
Photo 3 of 3 : UCIP_FA_2020_59652_86993.jpg

View of WS berm and channel looking from the levee crown.

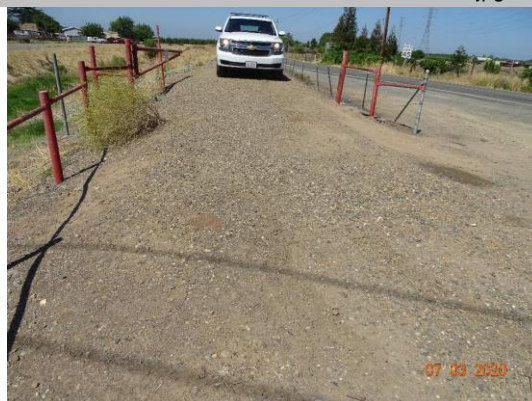
Photo 1 of 3 : UCIP_FA_2020_59653_86996.jpg

Comment Code						
Inspector Comment						
DS_ID:23876 FS_ID:59653 EP_NO: N/A Repair Type: Non-Urgent EVAL Issue: Unauthorized Encroachment, installed decades prior Crossing Status: Found UCIP Comments: 07/03/2020 Crossing evaluated as "Non-Urgent" because there was no permit found authorizing this pipe. (A. McDonald - DWR UCIP)Concrete inlet at LS of East Kettleman road is damaged...may or may not be a hazard. FIELD_STRUCT_DESC: 24-inch corrugated metal drainage pipe through the levee, 5 feet below the crown. Concrete U-shaped headwall on the waterside (WS) end. Flap gate on the WS end. Cobble grouted spillway. 36-inch concrete catch basin on the landside (LS) end. [Additional Reference(s): DWR Levee Log, 1978. USACE San Joaquin O&M Manual 612.2, 1967, (HLM 2.22)]. FS Date: 7/3/2020

Overview of levee crown looking d/s.

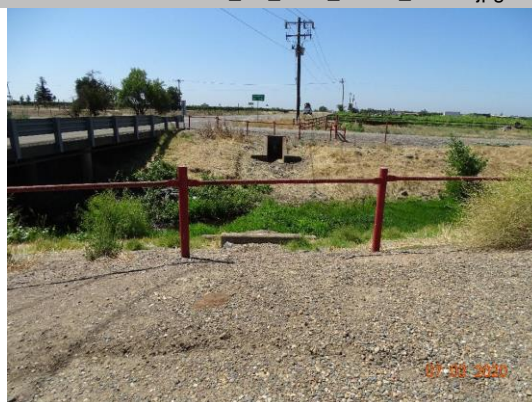
Photo 2 of 3 : UCIP_FA_2020_59653_86997.jpg

View of channel on WS and opposite levee.

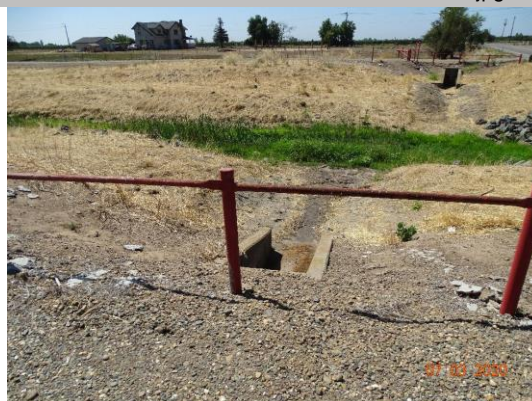
Photo 2 of 3 : UCIP_FA_2020_59656_87022.jpg

View of pipe outlet, WS channel, and opposite levee looking from the levee crown.

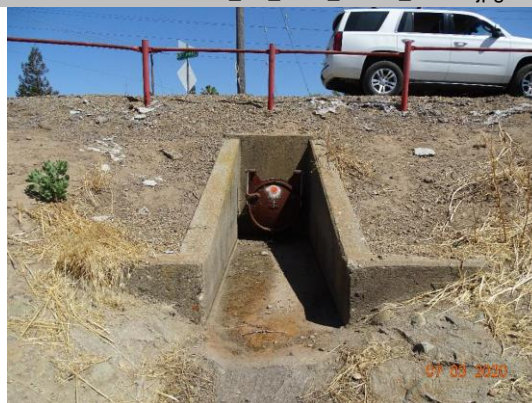
Photo 3 of 3 : UCIP_FA_2020_59656_87023.jpg

View of pipe outlet, flap gate, and headwall located at the WS levee toe.

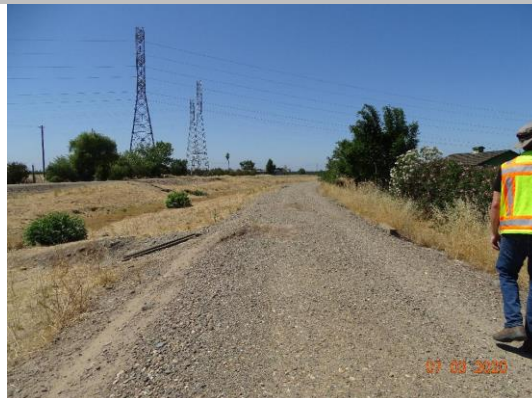
Photo 1 of 3 : UCIP_FA_2020_59658_87027.jpg

Comment Code						
Inspector Comment						
DS_ID:23886 FS_ID:59658 EP_NO: N/A Repair Type: Non-Urgent EVAL Issue: Unauthorized Encroachment, installed decades prior Crossing Status: Found UCIP Comments: 07/03/2020 Crossing evaluated as "Non-Urgent" because there was no permit found authorizing this pipe. (A. McDonald - DWR UCIP) FIELD_STRUCT_DESC: 24-inch corrugated metal drainage pipe through the levee, 4.5 feet below the crown. Concrete U-shaped headwall on both ends. Flap gate on the waterside (WS) end. Cobble grouted spillway. Cobble grouted intake on the landside (LS). [Additional Reference(s): DWR Levee Log, 1978. USACE San Joaquin O&M Manual 612.2, 1967, (HLM 2.44)]. FS Date: 7/3/2020

Overview of levee crown looking d/s.

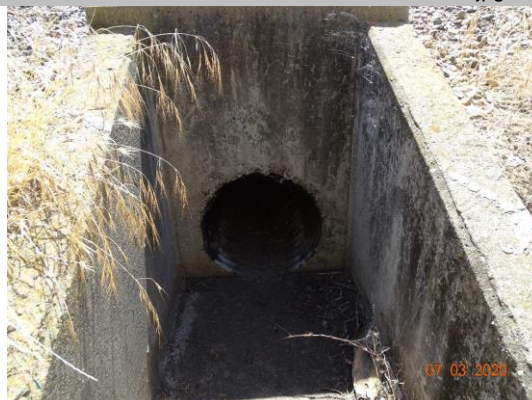
Photo 2 of 3 : UCIP_FA_2020_59658_87028.jpg

View of pipe inlet and headwall located at the LS levee toe.

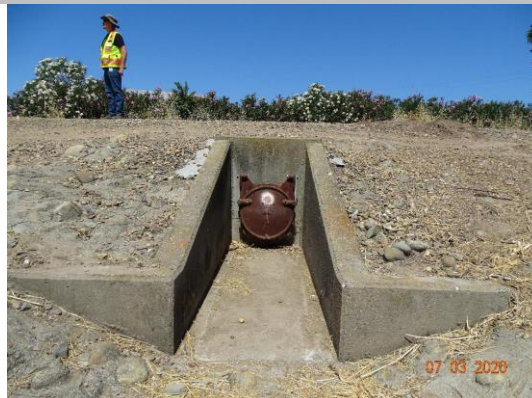
Photo 3 of 3 : UCIP_FA_2020_59658_87029.jpg

View of pipe outlet, flap gate, and headwall located at the WS levee toe.

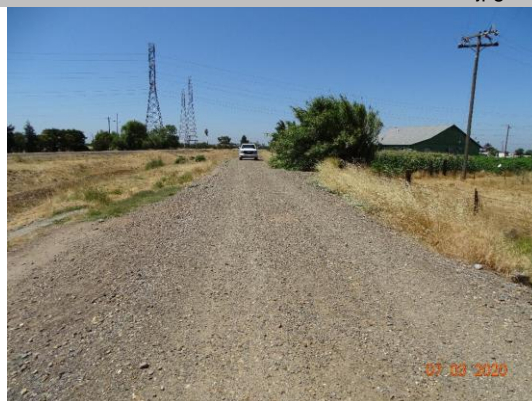
Photo 1 of 3 : UCIP_FA_2020_59659_87030.jpg

DS_ID:23887
 FS_ID:59659
 EP_NO: N/A
 Repair Type: Non-Urgent
 EVAL Issue: Unauthorized Encroachment, installed decades prior
 Crossing Status: Found
 UCIP Comments: 07/03/2020 Crossing evaluated as "Non-Urgent" because there was no permit found authorizing this pipe. (A. McDonald - DWR UCIP)
 FIELD_STRUCT_DESC: 24-inch corrugated metal drainage pipe through the levee, 5.5 feet below the crown. Concrete U-shaped headwall on both ends. Flap gate on the waterside (WS) end. Cobble grouted spillway. Cobble grouted intake on the landside (LS).
 [Additional Reference(s): DWR Levee Log, 1978. USACE San Joaquin O&M Manual 612.2, 1967, (HLM 2.48)].
 FS Date: 7/3/2020

Overview of levee crown looking d/s.

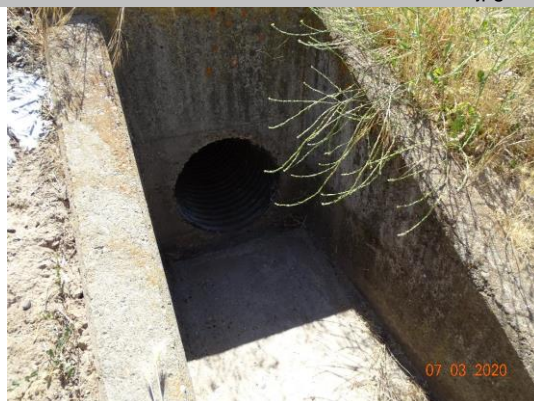
Photo 2 of 3 : UCIP_FA_2020_59659_87031.jpg

View of pipe inlet and headwall located at the LS levee toe.

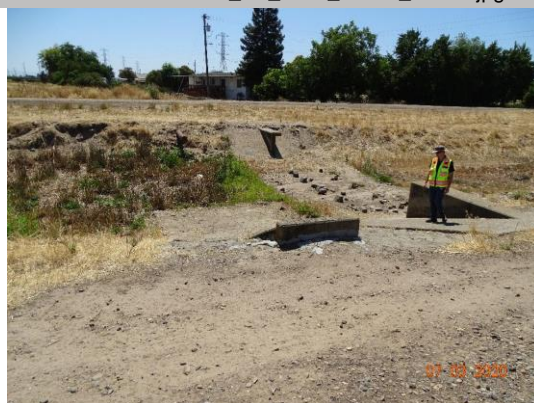
Photo 3 of 3 : UCIP_FA_2020_59659_87032.jpg

View of pipe outlet and channel located on the WS.

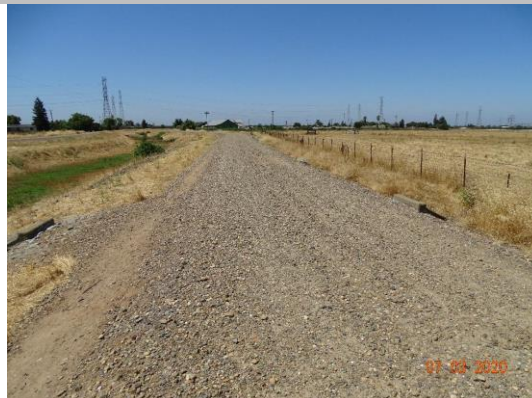
Photo 1 of 3 : UCIP_FA_2020_59660_87034.jpg

Comment Code					
Inspector Comment					
DS_ID:23888 FS_ID:59660 EP_NO: N/A Repair Type: Non-Urgent EVAL Issue: Unauthorized Encroachment, installed decades prior Crossing Status: Found UCIP Comments: 07/03/2020 Crossing evaluated as "Non-Urgent" because there was no permit found authorizing this pipe. Video inspection performed on 04-22-2020. (A. McDonald - DWR UCIP) FIELD_STRUCT_DESC: 24-inch corrugated metal drainage pipe through the levee, 6 feet below the crown. Concrete U-shaped headwall on both ends. Flap gate on the waterside (WS) end. Cobble grouted spillway. Cobble grouted intake on the landside (LS). [Additional Reference(s): DWR Levee Log, 1978. USACE San Joaquin O&M Manual 612.2, 1967, (HLM 2.58)]. FS Date: 7/3/2020

Overview of levee crown looking d/s.

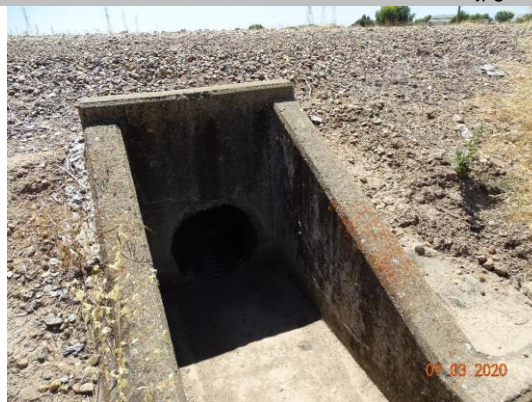
Photo 2 of 3 : UCIP_FA_2020_59660_87035.jpg

View of pipe inlet and headwall located at the LS levee toe.

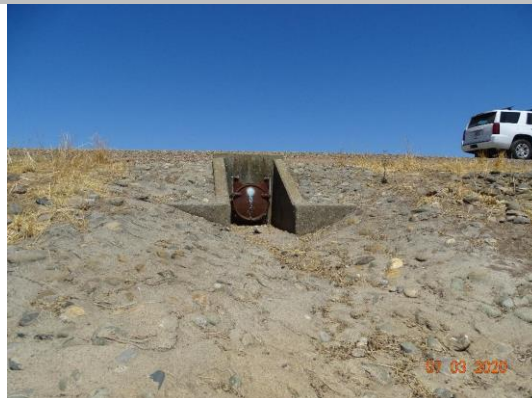
Photo 3 of 3 : UCIP_FA_2020_59660_87036.jpg

View of pipe outlet, flap gate, headwall, and splash apron located on the WS levee slope.

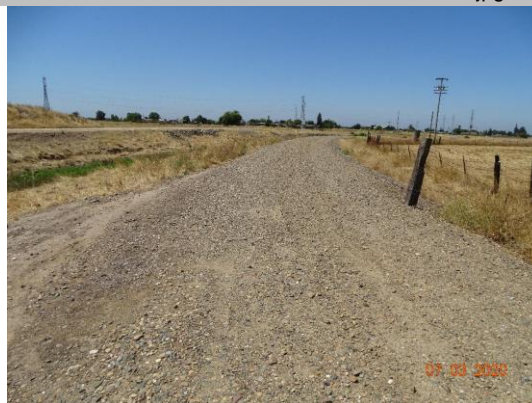
Photo 1 of 3 : UCIP_FA_2020_59670_87045.jpg

DS_ID:23890
 FS_ID:59670
 EP_NO: N/A
 Repair Type: No Action Needed
 EVAL Issue: Compliant
 Crossing Status: Found
 UCIP Comments: 07/03/2020 Crossing evaluated as "No Action Needed." Permit and inspection requirements have been met. Video inspection performed on 04-22-2020. (A. McDonald - DWR UCIP)
 FIELD_STRUCT_DESC: 36-inch corrugated metal drainage pipe through the levee, 7 feet below the crown. Concrete U-shaped headwall on both ends. Flap gate on the waterside (WS) end. Cobble grouted spillway. Cobble grouted intake on the landside (LS). (Positive closure device installed on intake end under Permit No. 17426, 2003 - Western Dairy Design Associates, Inc.). [Additional Reference(s): DWR Levee Log, 1978. USACE San Joaquin O&M Manual 612.2, 1967, (HLM 2.73)].
 FS Date: 7/3/2020

Overview of levee crown looking d/s.

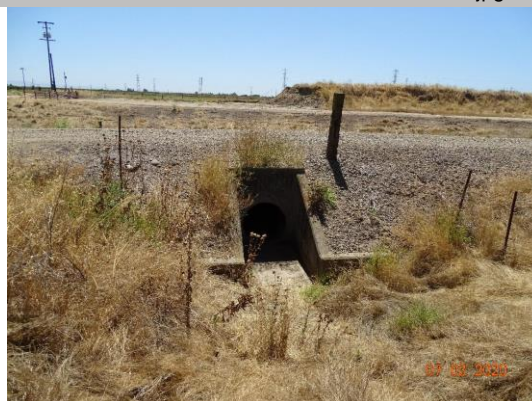
Photo 2 of 3 : UCIP_FA_2020_59670_87046.jpg

View of pipe inlet and headwall located at the LS levee toe.

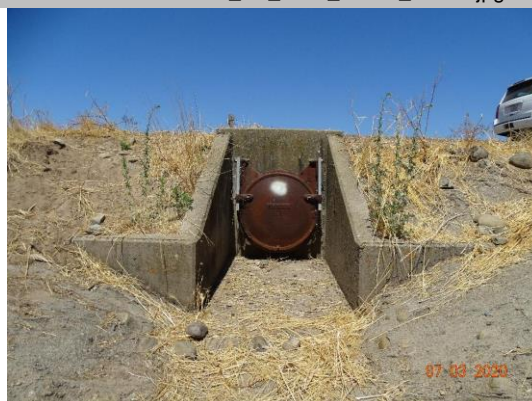
Photo 3 of 3 : UCIP_FA_2020_59670_87047.jpg

View of pipe outlet, flap gate, headwall, and splash apron located at the WS levee toe.

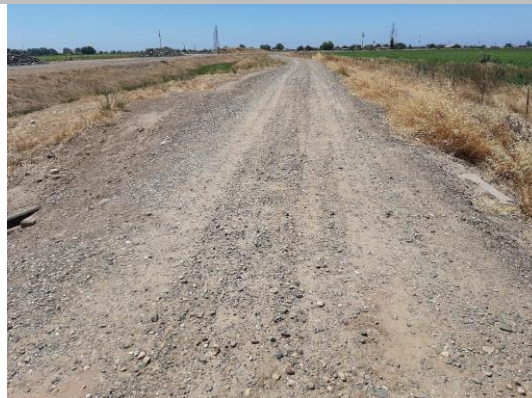
Photo 1 of 3 : UCIP_FA_2020_59663_87048.jpg

Comment Code					
Inspector Comment					
DS_ID:23891 FS_ID:59663 EP_NO: N/A Repair Type: Non-Urgent EVAL Issue: Unauthorized Encroachment, installed decades prior Crossing Status: Found UCIP Comments: 07/03/2020 Crossing evaluated as "Non-Urgent" because there was no permit found authorizing this pipe. Video inspection performed on 04-22-2020. (A. McDonald - DWR UCIP) FIELD_STRUCT_DESC: 24-inch corrugated metal drainage pipe through the levee, 6 feet below the crown. Concrete U-shaped headwall on both ends. Flap gate on the waterside (WS) end. Cobble grouted spillway. Cobble grouted intake on the landside (LS). [Additional Reference(s): DWR Levee Log, 1978. USACE San Joaquin O&M Manual 612.2, 1967, (HLM 2.88)]. FS Date: 7/3/2020

Overview of levee crown looking d/s.

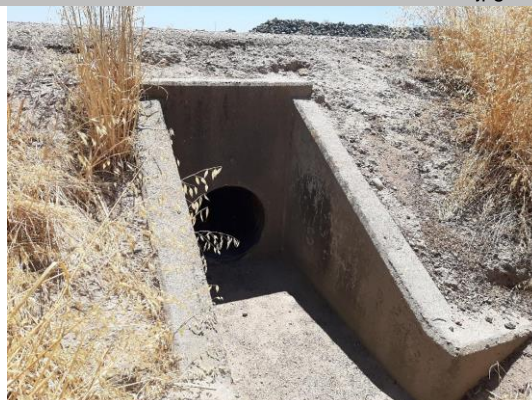
Photo 2 of 3 : UCIP_FA_2020_59663_87049.jpg

View of pipe inlet and headwall located at the LS levee toe.

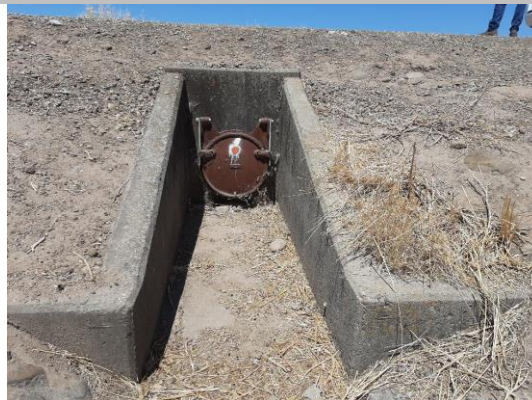
Photo 3 of 3 : UCIP_FA_2020_59663_87050.jpg

View of pipe outlet, flap gate, and headwall located at the WS levee toe.

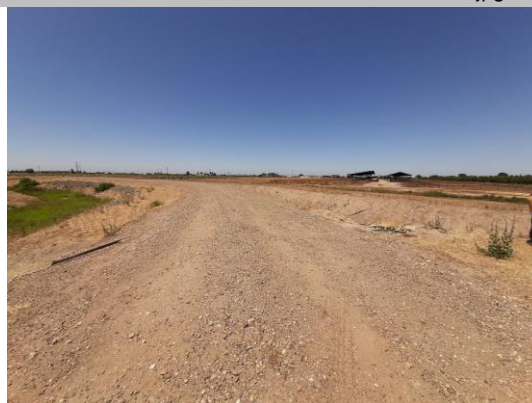
Photo 1 of 3 : UCIP_FA_2020_59665_87054.jpg

DS_ID:23892
 FS_ID:59665
 EP_NO: N/A
 Repair Type: Non-Urgent
 EVAL Issue: Abandoned encroachment
 Crossing Status: Found
 UCIP Comments: 07/03/2020 Crossing evaluated as "Non-Urgent" because this is an abandoned encroachment. Video inspection performed on 02-21-2020. (A. McDonald - DWR UCIP) Pipe abandoned and if so should be done so properly. Verify if possible pipe filled with concrete.
 FIELD_STRUCT_DESC: *ABANDONED* 24-inch corrugated metal drainage pipe through the levee, 6.5 feet below the crown. Concrete U-shaped headwall on both ends. Flap gate on the waterside (WS) end. Cobble grouted spillway. Cobble grouted intake on the landside (LS). (Intake end plugged, and pipe filled with concrete under Permit No. 17426, 2003 - Western Dairy Design Associates, Inc.). [Additional Reference(s): DWR Levee Log, 1978. USACE San Joaquin O&M Manual 612.2, 1967, (HLM 3.04)].
 FS Date: 7/3/2020

Overview of levee crown looking d/s.

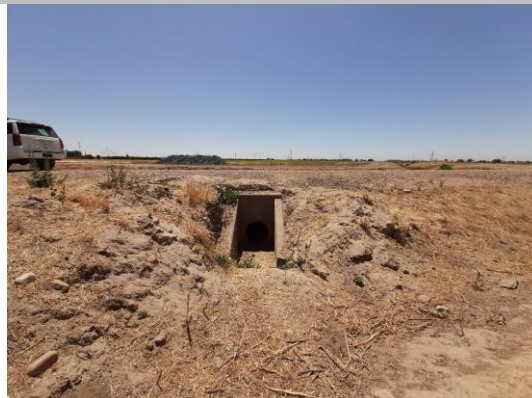
Photo 2 of 3 : UCIP_FA_2020_59665_87055.jpg

View of pipe inlet and headwall located at the LS levee toe.

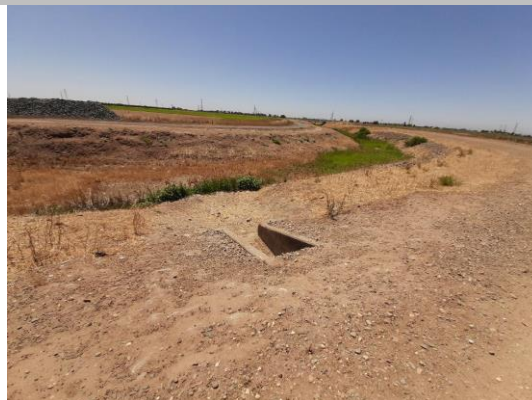
Photo 3 of 3 : UCIP_FA_2020_59665_87056.jpg

View of pipe outlet and WS channel.

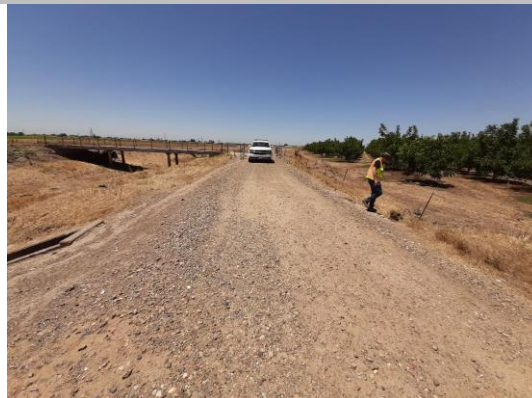
Photo 1 of 3 : UCIP_FA_2020_59666_87058.jpg

LM Start	3.13	Rating **	M	Issue No.	232
LM End	3.13	Issue Type +	Ma	Location *	
Category	Supplemental			GPS Latitude/Longitude	
				Start	End
Item	DWR UCIP LMA Responsibility			38.127210 °	38.127210 °
				-121.142099 °	-121.142099 °
DWR ID	23893				
Comment Code					
Inspector Comment					
DS_ID:23893					
FS_ID:59666					
EP_NO: N/A					
Repair Type: Non-Urgent					
EVAL Issue: Unauthorized Encroachment, installed decades prior					
Crossing Status: Found					
UCIP Comments: 07/03/2020 Crossing evaluated as "Non-Urgent" because there was no permit found authorizing this pipe. (A. McDonald - DWR UCIP)					
FIELD_STRUCT_DESC: 24-inch corrugated metal drainage pipe through the levee, 4.6 feet below the crown. Flap gate on the waterside (WS) end. [Additional Reference(s): DWR Levee Log, 1978. USACE San Joaquin O&M Manual 612.2, 1967, (HLM 3.15)].					
FS Date: 7/3/2020

Overview of levee crown looking d/s.

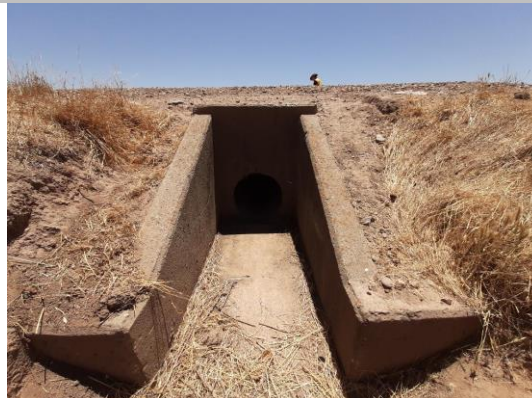
Photo 2 of 3 : UCIP_FA_2020_59666_87059.jpg

View of pipe inlet and headwall located at the LS levee toe.

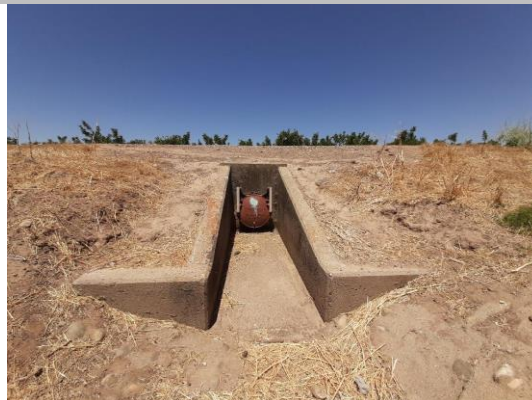
Photo 3 of 3 : UCIP_FA_2020_59666_87060.jpg

View of pipe outlet, flap gate, and headwall located at the WS levee toe.

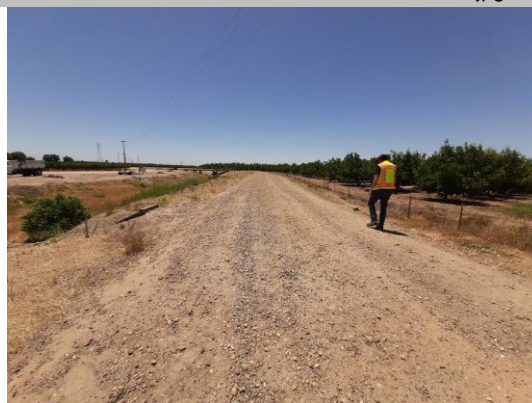
Photo 1 of 3 : UCIP_FA_2020_59668_87065.jpg

Overview of levee crown looking d/s.

Comment Code					
Inspector Comment					
DS_ID:23895 FS_ID:59668 EP_NO: N/A Repair Type: Non-Urgent EVAL Issue: Unauthorized Encroachment, installed decades prior Crossing Status: Found UCIP Comments: 07/03/2020 Crossing evaluated as "Non-Urgent" because there was no permit found authorizing this pipe. (A. McDonald - DWR UCIP) FIELD_STRUCT_DESC: 24-inch corrugated metal drainage pipe through the levee, 5 feet below the crown. Concrete U-shaped headwall on both ends. Flap gate on the waterside (WS) end. Cobble grouted spillway. Cobble grouted intake on the landside (LS). [Additional Reference(s): DWR Levee Log, 1978. USACE San Joaquin O&M Manual 612.2, 1967, (HLM 3.47)]. FS Date: 7/3/2020

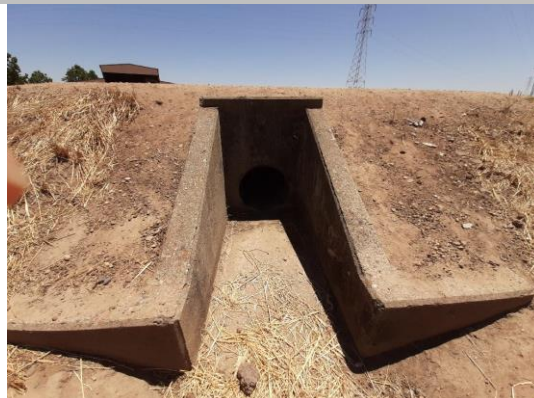
Photo 2 of 3 : UCIP_FA_2020_59668_87066.jpg

View of pipe inlet and headwall located at the LS levee toe.

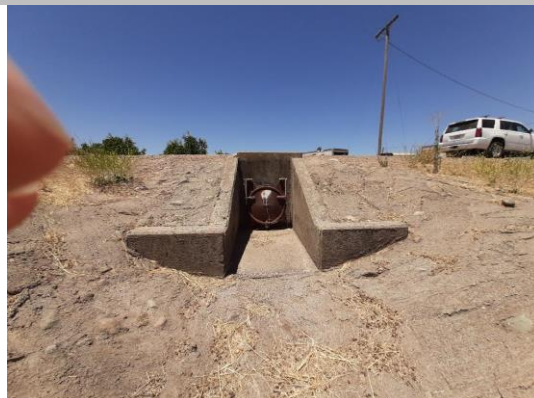
Photo 3 of 3 : UCIP_FA_2020_59668_87067.jpg

View of pipe outlet, flap gate, and headwall located at the WS levee toe.

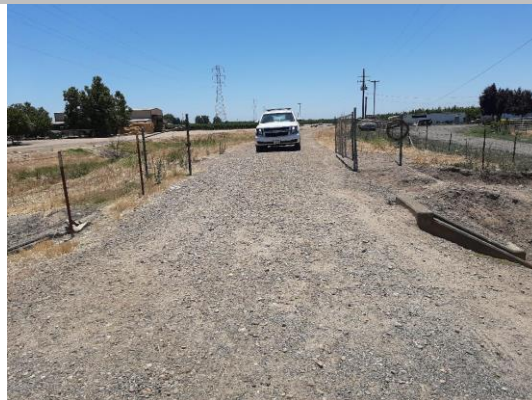
Photo 1 of 3 : UCIP_FA_2020_59669_87068.jpg

Comment Code						
Inspector Comment						
DS_ID:23896 FS_ID:59669 EP_NO: N/A Repair Type: Non-Urgent EVAL Issue: Unauthorized Encroachment, installed decades prior Crossing Status: Found UCIP Comments: 07/03/2020 Crossing evaluated as "Non-Urgent" because there was no permit found authorizing this pipe. Video inspection performed on 04-22-2020. (A. McDonald - DWR UCIP) FIELD_STRUCT_DESC: 24-inch corrugated metal drainage pipe through the levee, 4.5 feet below the crown. Concrete U-shaped headwall on both ends. Flap gate on the waterside (WS) end. Cobble grouted intake on the landside (LS). [Additional Reference(s): DWR Levee Log, 1978. USACE San Joaquin O&M Manual 612.2, 1967, (HLM 3.55)]. FS Date: 7/3/2020

Overview of levee crown looking d/s.

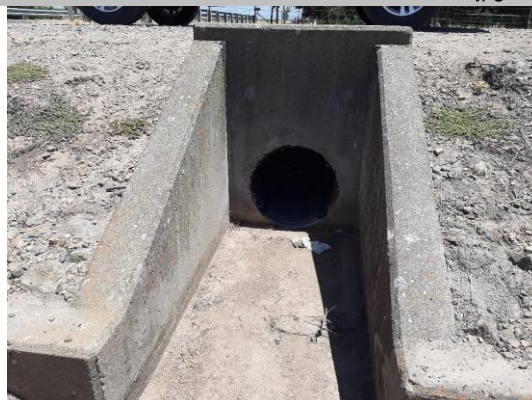
Photo 2 of 3 : UCIP_FA_2020_59669_87069.jpg

View of pipe inlet and headwall located at the LS levee toe.

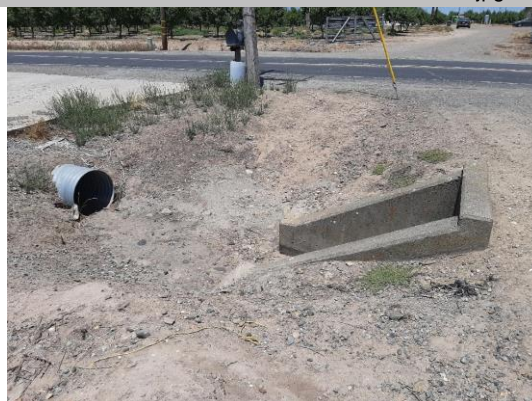
Photo 3 of 3 : UCIP_FA_2020_59669_87070.jpg

Drainage pipe under driveway leading to the inlet at the LS levee toe.

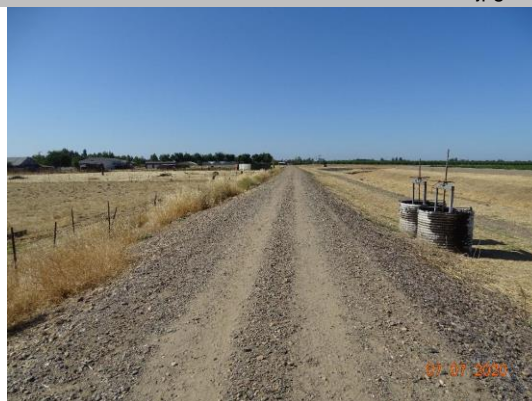
Photo 1 of 3 : UCIP_FA_2020_59601_87072.jpg

Comment Code					
Inspector Comment					
DS_ID:23925 FS_ID:59601 EP_NO: N/A Repair Type: Non-Urgent EVAL Issue: Unauthorized Encroachment, installed decades prior Crossing Status: Found UCIP Comments: 07/07/2020 Crossing evaluated as "Non-Urgent" because there was no permit found authorizing this pipe. Video inspection performed on 05-07-2020. (A. McDonald - DWR UCIP)Gate valve rusted in place. No lid or cover on Standpipe on WS slope. FIELD_STRUCT_DESC: 1 of 2: 42-inch corrugated metal drainage pipe through the levee, 7 feet below the crown. Slide gate in a 56-inch corrugated metal riser unit on the waterside (WS) slope. Flap gate on the WS end. Concrete headwall on both ends. [Additional Reference(s): DWR Levee Log, 1978. USACE San Joaquin O&M Manual 612.2, 1967, (HLM 0.14) 36-inch pipe listed]. FS Date: 7/7/2020

Overview of levee crown looking d/s.

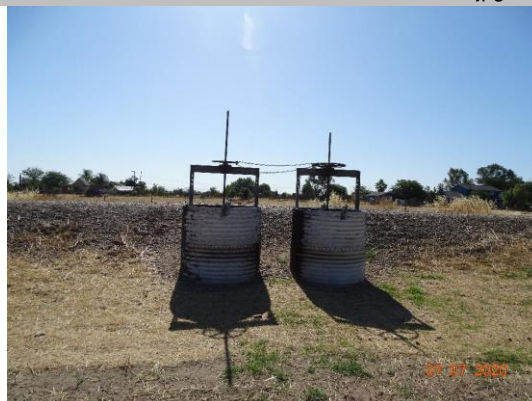
Photo 2 of 3 : UCIP_FA_2020_59601_87073.jpg

Two risers with gate valves located on the WS levee slope.

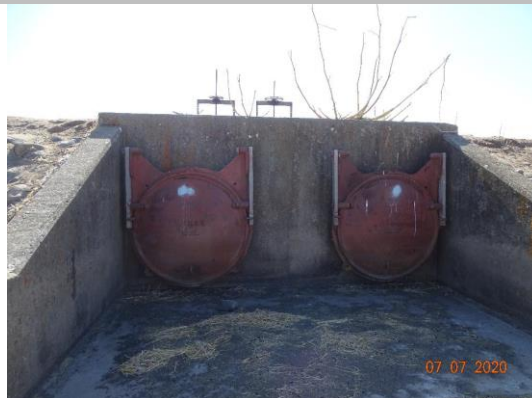
Photo 3 of 3 : UCIP_FA_2020_59601_87074.jpg

Two pipe outlets, flap gates, and headwall located on the WS berm.

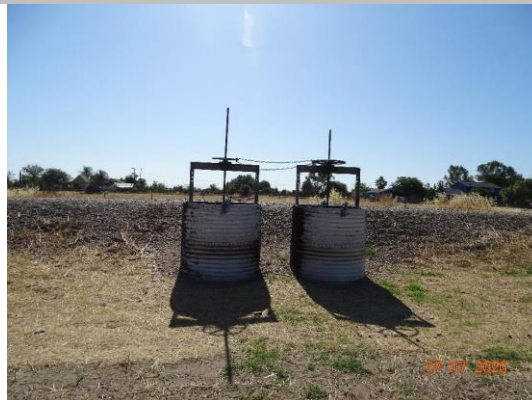
Photo 2 of 3 : UCIP_FA_2020_59602_87077.jpg

Comment Code					
Inspector Comment					
DS_ID:23930 FS_ID:59602 EP_NO: N/A Repair Type: Non-Urgent EVAL Issue: Unauthorized Encroachment, installed decades prior Crossing Status: Found UCIP Comments: 07/07/2020 Crossing evaluated as "Non-Urgent" because there was no permit found authorizing this pipe. (A. McDonald - DWR UCIP)No lid on riser and slide gate actuator rusted in place. FIELD_STRUCT_DESC: 2 of 2: 42-inch corrugated metal drainage pipe through the levee, 7 feet below the crown. Slide gate in 56-inch corrugated metal riser unit on the waterside (WS) slope. Flap gate on the WS end. [Additional Reference(s): DWR Levee Log, 1978. USACE San Joaquin O&M Manual 612.2, 1967, (HLM 0.14) 36-inch pipe listed]. FS Date: 7/7/2020

Two risers and gate valves located on the WS levee slope.

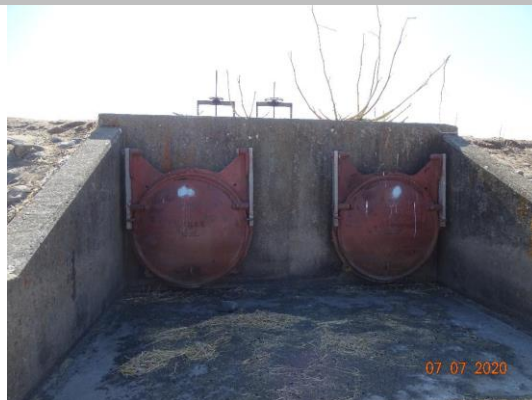
Photo 3 of 3 : UCIP_FA_2020_59602_87078.jpg

Two pipe outlets, flap gates, and headwall located on the WS berm.

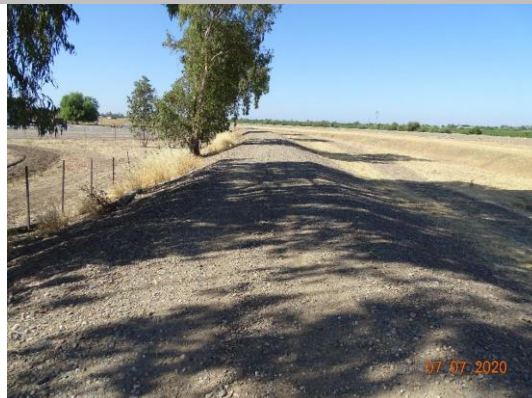
Photo 1 of 3 : UCIP_FA_2020_59603_87080.jpg

Comment Code						
Inspector Comment						
DS_ID:23900 FS_ID:59603 EP_NO: N/A Repair Type: Non-Urgent EVAL Issue: Unauthorized Encroachment, installed decades prior Crossing Status: Found UCIP Comments: 07/07/2020 Crossing evaluated as "Non-Urgent" because there was no permit found authorizing this pipe. (A. McDonald - DWR UCIP) FIELD_STRUCT_DESC: 24-inch corrugated metal drainage pipe through the levee, 6.5 feet below the crown. Concrete U-shaped headwall on both ends. Flap gate on the waterside (WS) end. Cobble grouted spillway. Cobble grouted intake on the landside (LS). [Additional Reference(s): DWR Levee Log, 1978. USACE San Joaquin O&M Manual 612.2, 1967, (HLM 0.40)]. FS Date: 7/7/2020

Overview of levee crown looking d/s.

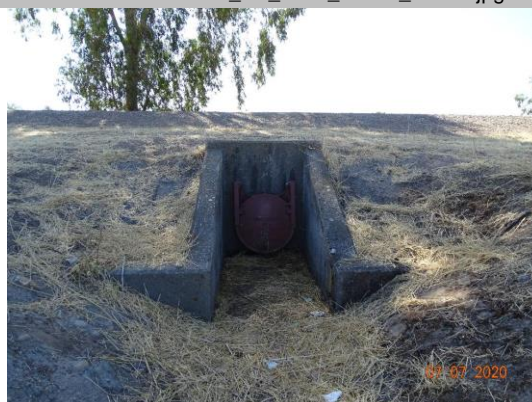
Photo 2 of 3 : UCIP_FA_2020_59603_87081.jpg

View of pipe outlet, flap gate, and headwall located on the WS berm.

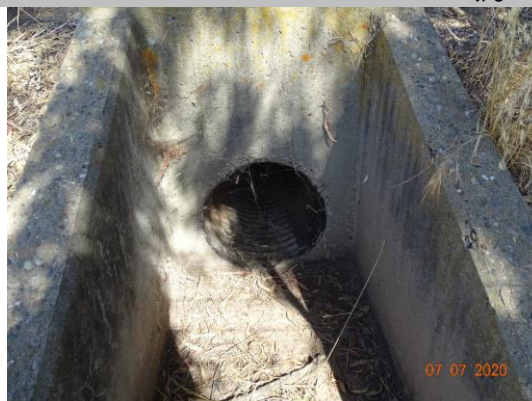
Photo 3 of 3 : UCIP_FA_2020_59603_87082.jpg

View of pipe inlet and headwall located at the LS levee toe.
