**Flood Control Project Maintenance
Levee Inspections**

Maintenance Issue Types Only, Levee Inspection Report By Mile - Fall 2020

San Joaquin County Flood Control and Water Conservation District

Waterway	Bank	Unit Miles	Inspection Start/End	Inspector
Unit No. 01 Littlejohn Creek	Left	2.59	10/20/2020 10/20/2020	Alberto De Leon

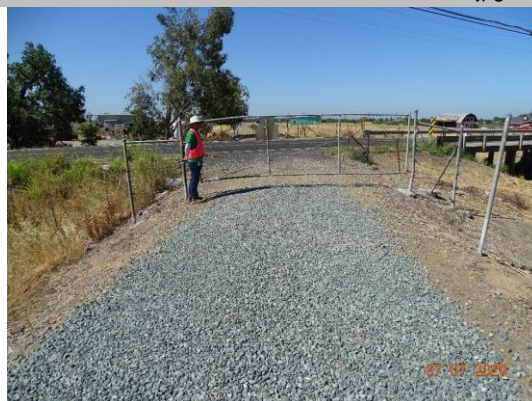
Photo 1 of 3 : UCIP_FA_2020_59605_87089.jpg

Comment Code						
Inspector Comment						
DS_ID:23901 FS_ID:59605 EP_NO: N/A Repair Type: Non-Urgent EVAL Issue: Unauthorized Encroachment, installed decades prior Crossing Status: Found UCIP Comments: 07/07/2020 Crossing evaluated as "Non-Urgent" because there was no permit found authorizing this pipe. (A. McDonald - DWR UCIP) FIELD_STRUCT_DESC: 24-inch corrugated metal drainage pipe through the levee, 7 feet below the crown. Concrete U-shaped headwall on both ends. Flap gate on the waterside (WS) end. Cobble grouted spillway. Cobble grouted intake on the landside (LS) end. [Additional Reference(s): DWR Levee Log, 1978. USACE San Joaquin O&M Manual 612.2, 1967, (HLM 0.48)]. FS Date: 7/7/2020

Overview of levee crown looking d/s.

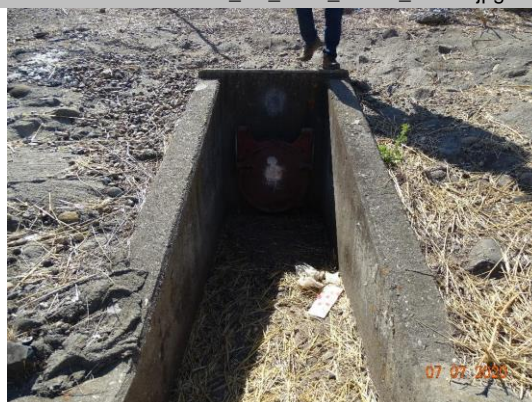
Photo 2 of 3 : UCIP_FA_2020_59605_87090.jpg

View of pipe outlet, flap gate, and headwall located at the WS levee toe.

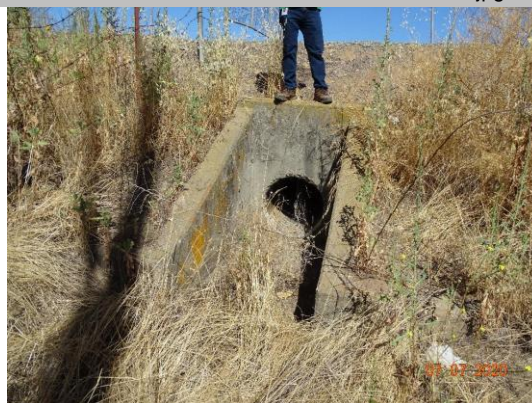
Photo 3 of 3 : UCIP_FA_2020_59605_87091.jpg

View of pipe inlet and headwall located at the LS levee toe.

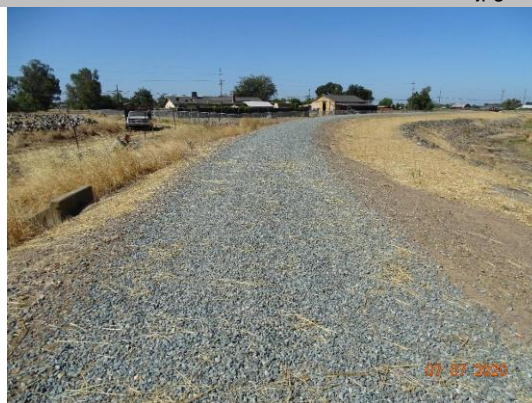
Photo 1 of 3 : UCIP_FA_2020_59606_87092.jpg

DS_ID:23902
 FS_ID:59606
 EP_NO: N/A
 Repair Type: Non-Urgent
 EVAL Issue: Unauthorized Encroachment, installed decades prior
 Crossing Status: Found
 UCIP Comments: 07/07/2020 Crossing evaluated as "Non-Urgent" because there was no permit found authorizing this pipe. (A. McDonald - DWR UCIP)
 FIELD_STRUCT_DESC: 24-inch corrugated metal drainage pipe through the levee, 4 feet below the crown. Concrete U-shaped headwall on both ends. Flap gate on the waterside (WS) end. Cobble grouted spillway. Cobble grouted intake on the landside (LS). [Additional Reference(s): DWR Levee Log, 1978. USACE San Joaquin O&M Manual 612.2, 1967, (HLM 0.61)].
 FS Date: 7/7/2020

Overview of levee crown looking d/s.

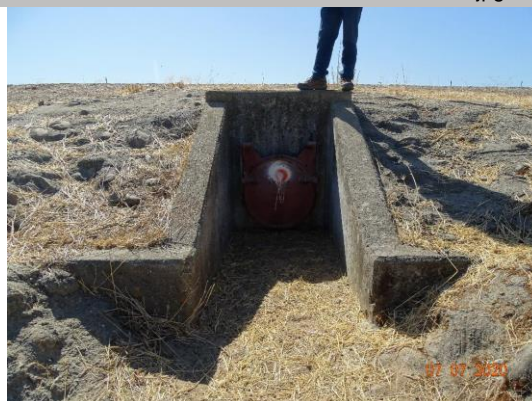
Photo 2 of 3 : UCIP_FA_2020_59606_87093.jpg

View of pipe outlet, flap gate, and headwall located at the WS levee toe.

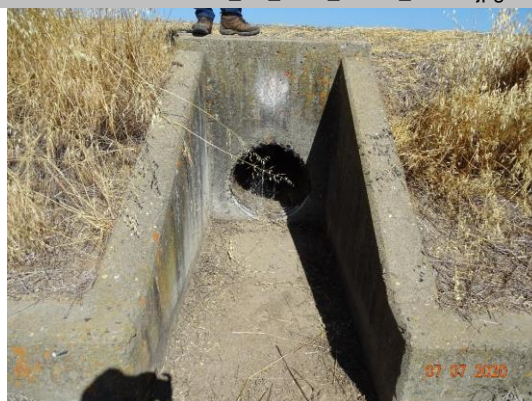
Photo 3 of 3 : UCIP_FA_2020_59606_87094.jpg

View of pipe inlet and headwall located at the LS levee toe.

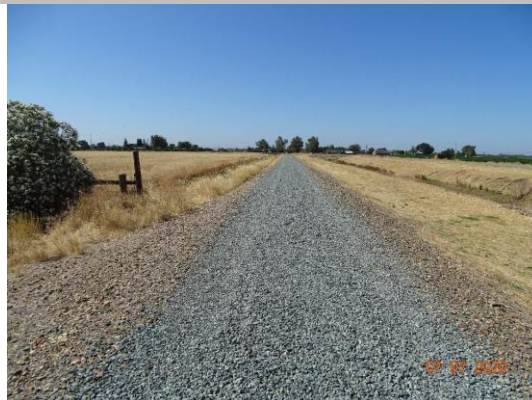
Photo 1 of 3 : UCIP_FA_2020_59607_87095.jpg

Comment Code						
Inspector Comment						
DS_ID:23903 FS_ID:59607 EP_NO: N/A Repair Type: Non-Urgent EVAL Issue: Unauthorized Encroachment, installed decades prior Crossing Status: Found UCIP Comments: 07/07/2020 Crossing evaluated as "Non-Urgent" because there was no permit found authorizing this pipe. Video inspection performed on 04-24-2020. (A. McDonald - DWR UCIP) FIELD_STRUCT_DESC: 24-inch corrugated metal drainage pipe through the levee, 5.5 feet below the crown. Concrete U-shaped headwalls on both ends. Flap gate on the waterside (WS) end. Cobble grouted spillway. Cobble grouted intake on the landside (LS) end. [Additional Reference(s): DWR Levee Log, 1978. USACE San Joaquin O&M Manual 612.2, 1967, (HLM 0.77)]. FS Date: 7/7/2020

Overview of levee crown looking d/s.

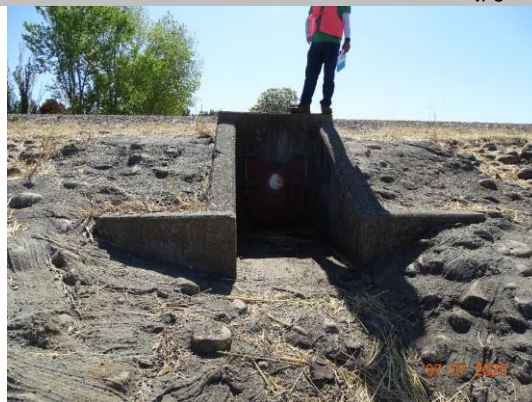
Photo 2 of 3 : UCIP_FA_2020_59607_87096.jpg

View of pipe outlet, flap gate, headwall, and splash apron located on the WS berm.

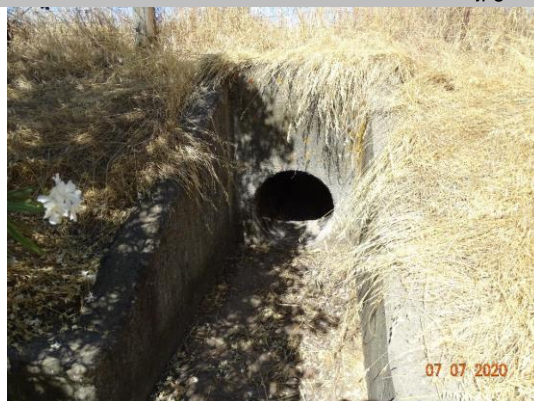
Photo 3 of 3 : UCIP_FA_2020_59607_87097.jpg

View of pipe inlet and headwall located at the LS levee toe.

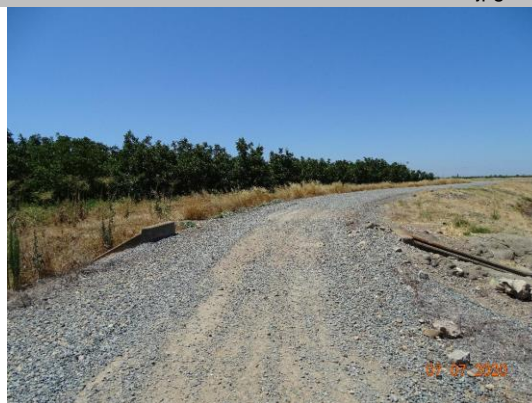
Photo 1 of 3 : UCIP_FA_2020_59608_87098.jpg

Comment Code						
Inspector Comment						
DS_ID:23904 FS_ID:59608 EP_NO: N/A Repair Type: Non-Urgent EVAL Issue: Unauthorized Encroachment, installed decades prior Crossing Status: Found UCIP Comments: 07/07/2020 Crossing evaluated as "Non-Urgent" because there was no permit found authorizing this pipe. (A. McDonald - DWR UCIP) FIELD_STRUCT_DESC: 24-inch corrugated metal drainage pipe through the levee, 2 feet below the crown. Concrete U-shaped headwalls on both ends. Flap gate on the waterside (WS) end. Cobble grouted spillway. Cobble grouted intake on the landside (LS). [Additional Reference(s): DWR Levee Log, 1978. USACE San Joaquin O&M Manual 612.2, 1967, (HLM 1.51)]. FS Date: 7/7/2020

Overview of levee crown looking d/s.

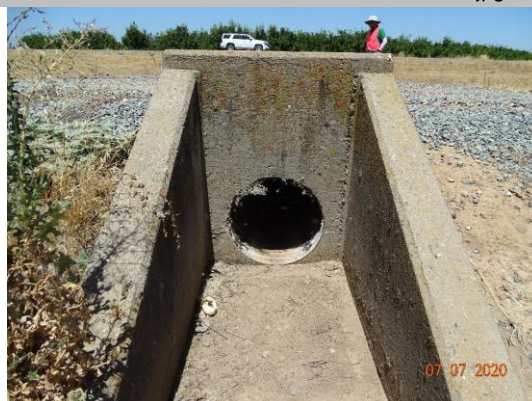
Photo 2 of 3 : UCIP_FA_2020_59608_87099.jpg

View of pipe inlet and headwall located at the LS levee toe.

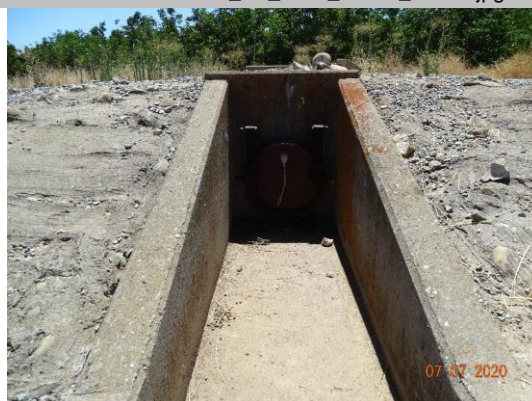
Photo 3 of 3 : UCIP_FA_2020_59608_87100.jpg

View of pipe outlet, flap gate, and headwall located on the WS berm.

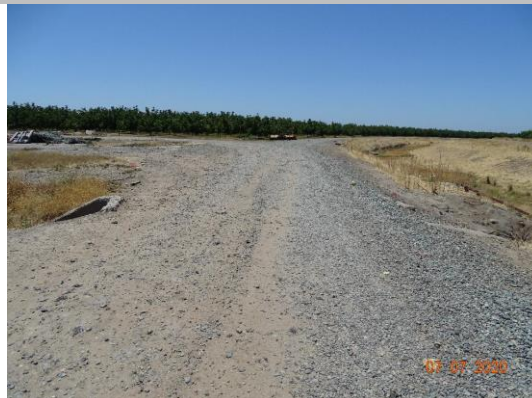
Photo 1 of 3 : UCIP_FA_2020_59609_87101.jpg

Comment Code						
Inspector Comment						
DS_ID:23905 FS_ID:59609 EP_NO: N/A Repair Type: Non-Urgent EVAL Issue: Unauthorized Encroachment, installed decades prior Crossing Status: Found UCIP Comments: 07/07/2020 Crossing evaluated as "Non-Urgent" because there was no permit found authorizing this pipe. Pipe inlet is clear of debris. (A. McDonald - DWR UCIP)Pipe is covered with soil at inlet on LS. FIELD_STRUCT_DESC: 24-inch corrugated metal drainage pipe through the levee, 3.5 feet below the crown. Concrete U-shaped headwalls on both ends. Flap gate on the waterside (WS) end. Cobble grouted spillway. Cobble grouted intake on the landside (LS). [Additional Reference(s): DWR Levee Log, 1978. USACE San Joaquin O&M Manual 612.2, 1967, (HLM 1.90)]. FS Date: 7/7/2020

Overview of levee crown looking d/s.

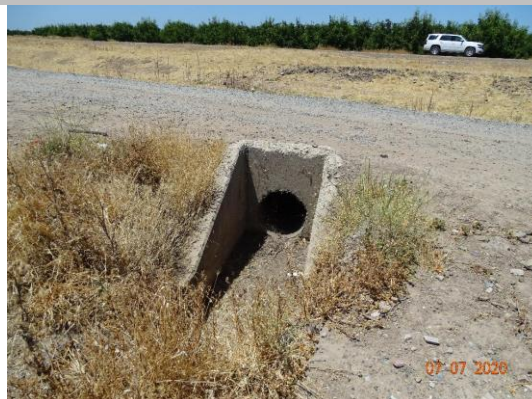
Photo 2 of 3 : UCIP_FA_2020_59609_87102.jpg

View of pipe inlet and headwall located at the LS levee toe.

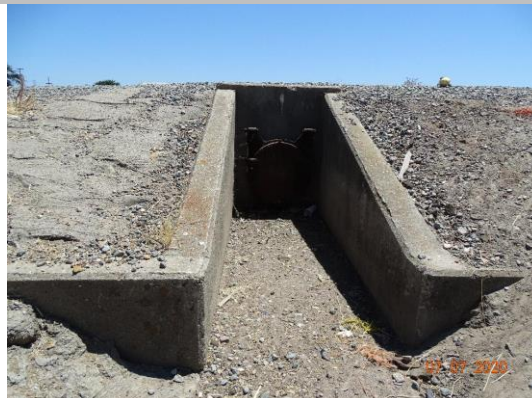
Photo 3 of 3 : UCIP_FA_2020_59609_87103.jpg

View of pipe outlet, flap gate, and headwall located at the WS levee toe.

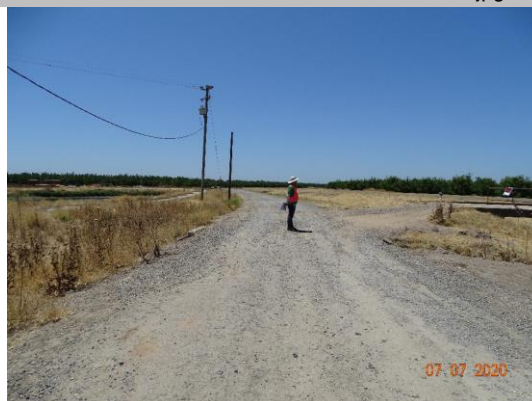
Photo 1 of 3 : UCIP_FA_2020_59610_87104.jpg

DS_ID:23906
 FS_ID:59610
 EP_NO: N/A
 Repair Type: Non-Urgent
 EVAL Issue: Unauthorized Encroachment, installed decades prior
 Crossing Status: Found
 UCIP Comments: 07/07/2020 Crossing evaluated as "Non-Urgent" because there was no permit found authorizing this pipe. Pipe no longer buried and not abandoned. Video inspection performed on 04-22-2020. (A. McDonald - DWR UCIP) Pipe buried on both ends and appears to be abandoned. If so, it should be done so properly.
 FIELD_STRUCT_DESC: 24-inch corrugated metal drainage pipe through the levee, 4 feet below the crown. Concrete U-shaped headwall on both ends. Flap gate on the waterside (WS) end. Cobble grouted spillway. Cobble grouted intake on the landside (LS). [Additional Reference(s): DWR Levee Log, 1978. USACE San Joaquin O&M Manual 612.2, 1967, (HLM 1.96)].
 FS Date: 7/7/2020

Overview of levee crown looking d/s.

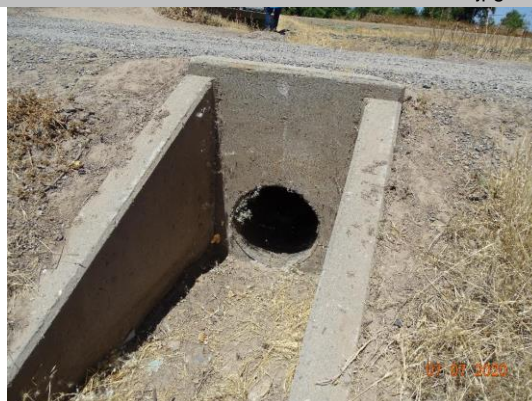
Photo 2 of 3 : UCIP_FA_2020_59610_87105.jpg

View of pipe inlet and headwall located at the LS levee toe.

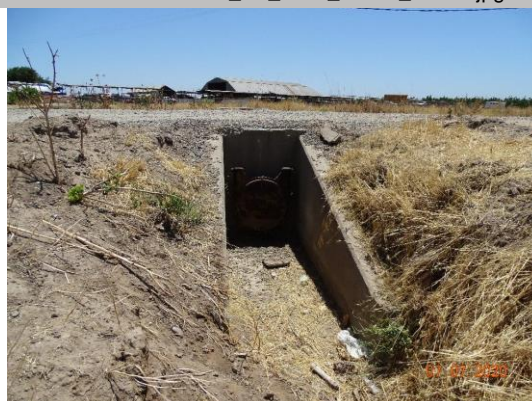
Photo 3 of 3 : UCIP_FA_2020_59610_87106.jpg

View of pipe outlet, flap gate, and headwall located at the WS levee toe.

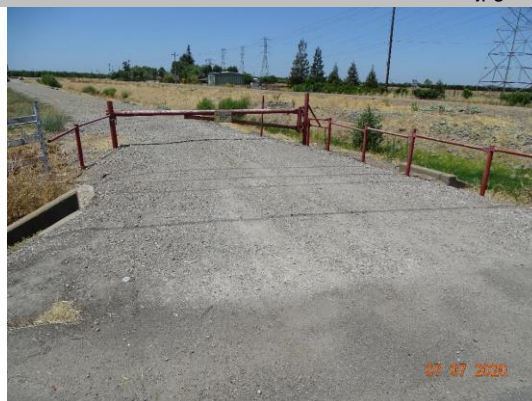
Photo 1 of 3 : UCIP_FA_2020_59613_87120.jpg

Comment Code					
Inspector Comment					
DS_ID:23908 FS_ID:59613 EP_NO: N/A Repair Type: Non-Urgent EVAL Issue: Unauthorized Encroachment, installed decades prior Crossing Status: Found UCIP Comments: 07/07/2020 Crossing evaluated as "Non-Urgent" because there was no permit found authorizing this pipe. Video inspection performed on 04-21-2020. (A. McDonald - DWR UCIP) FIELD_STRUCT_DESC: 24-inch corrugated metal drainage pipe through the levee, 4 feet below the crown. Concrete U-shaped headwalls on both ends. Flap gate on the waterside (WS) end. Cobble grouted spillway. Cobble grouted intake on the landside (LS). [Additional Reference(s): DWR Levee Log, 1978. USACE San Joaquin O&M Manual 612.2, 1967, (HLM 2.15)]. FS Date: 7/7/2020

Overview of levee crown looking d/s.

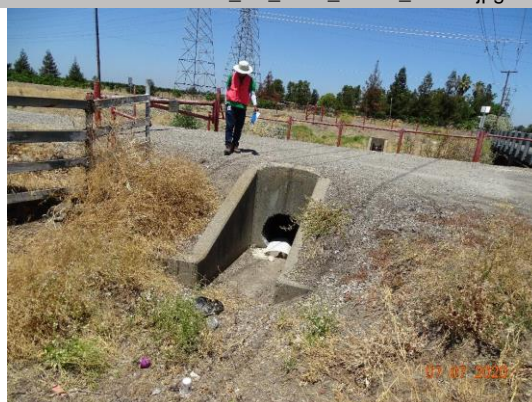
Photo 2 of 3 : UCIP_FA_2020_59613_87121.jpg

View of pipe inlet and headwall located at the LS levee toe.

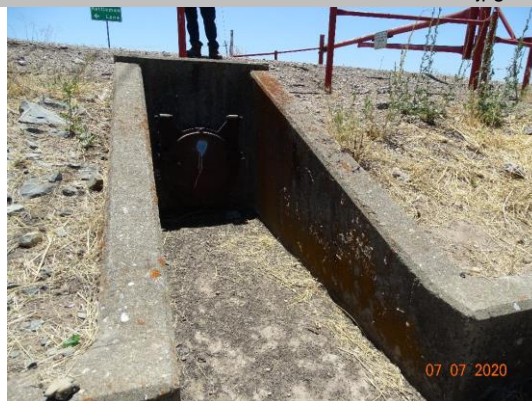
Photo 3 of 3 : UCIP_FA_2020_59613_87122.jpg

View of pipe outlet, flap gate, and headwall located at the WS levee toe.

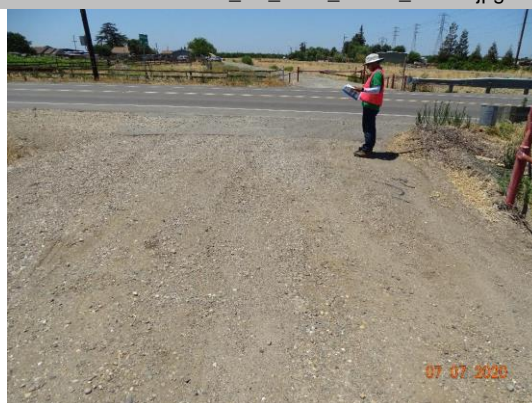
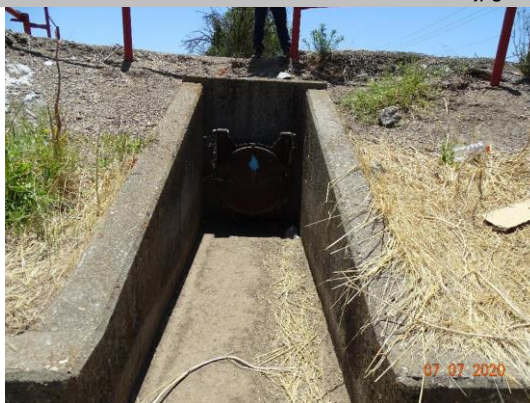
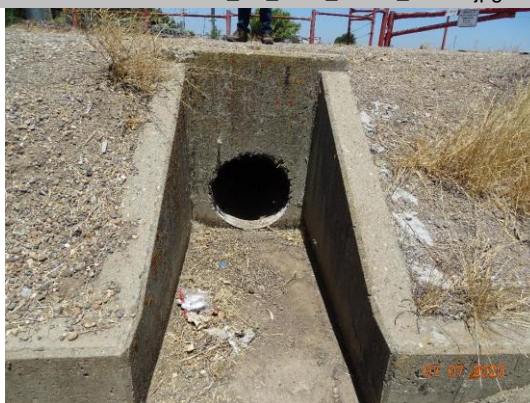
Photo 1 of 3 : UCIP_FA_2020_59617_87134.jpg

DS_ID:23909
 FS_ID:59617
 EP_NO: N/A
 Repair Type: Non-Urgent
 EVAL Issue: Unauthorized Encroachment, installed decades prior
 Crossing Status: Found
 UCIP Comments: 07/07/2020 Crossing evaluated as "Non-Urgent" because there was no permit found authorizing this pipe. (A. McDonald - DWR UCIP)
 FIELD_STRUCT_DESC: 24-inch corrugated metal drainage pipe through the levee, 5 feet below the crown. Concrete U-shaped headwalls on both ends. Flap gate on the waterside (WS) end. Cobble grouted spillway. Cobble grouted intake on the landside (LS).
 [Additional Reference(s): DWR Levee Log, 1978. USACE San Joaquin O&M Manual 612.2, 1967, (HLM 2.16)].
 FS Date: 7/7/2020

Overview of levee crown looking d/s.

View of pipe outlet, flap gate, and headwall located at the WS levee toe.

View of pipe inlet and headwall located at the LS levee toe.

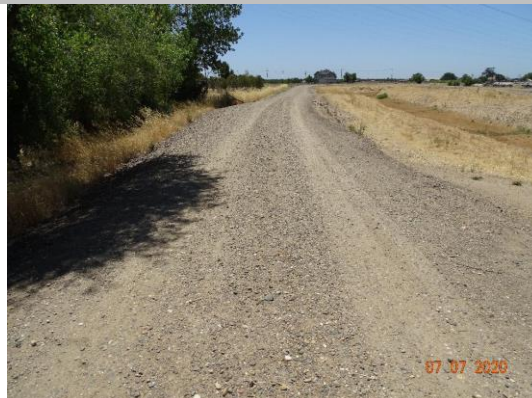
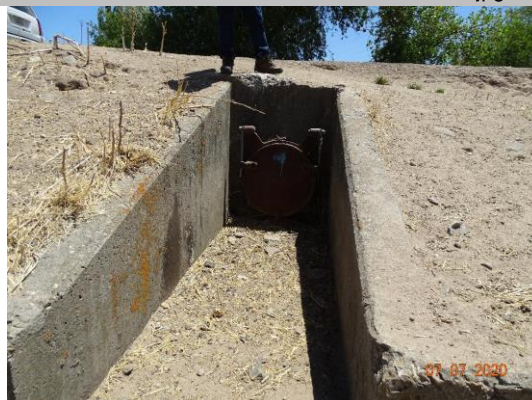
Photo 1 of 3 : UCIP_FA_2020_59624_87162.jpg

Comment Code					
Inspector Comment					
DS_ID:23911 FS_ID:59624 EP_NO: N/A Repair Type: Non-Urgent EVAL Issue: Unauthorized Encroachment, installed decades prior Crossing Status: Found UCIP Comments: 07/07/2020 Crossing evaluated as "Non-Urgent" because there was no permit found authorizing this pipe. (A. McDonald - DWR UCIP) FIELD_STRUCT_DESC: 24-inch corrugated metal drainage pipe through the levee, 6 feet below the crown. Concrete U-shaped headwalls on both ends. Flap gate on the waterside (WS) end. Cobble grouted spillway. Cobble grouted intake on the landside (LS). [Additional Reference(s): DWR Levee Log, 1978. USACE San Joaquin O&M Manual 612.2, 1967, (HLM 2.36)]. FS Date: 7/7/2020

Overview of levee crown looking d/s.

View of pipe outlet, flap gate, and headwall located at the WS levee toe.

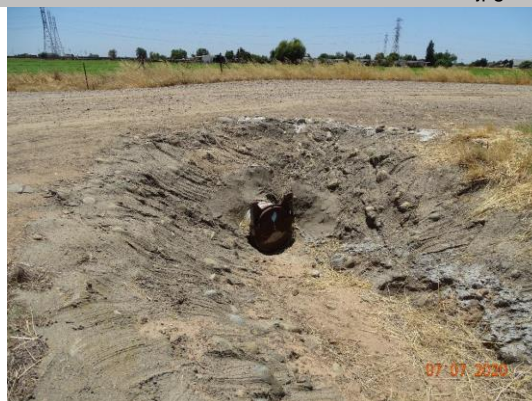
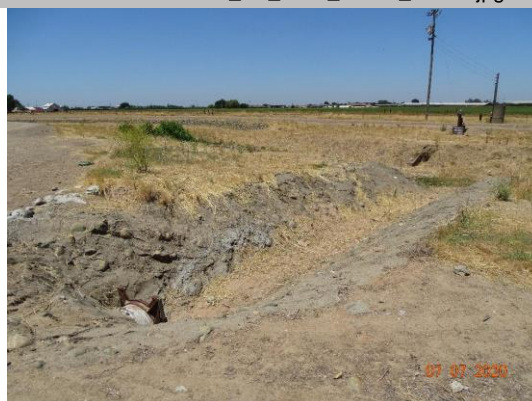
Photo 2 of 3 : UCIP_FA_2020_59626_87170.jpg

View of pipe outlet and spillway located at the WS levee toe.

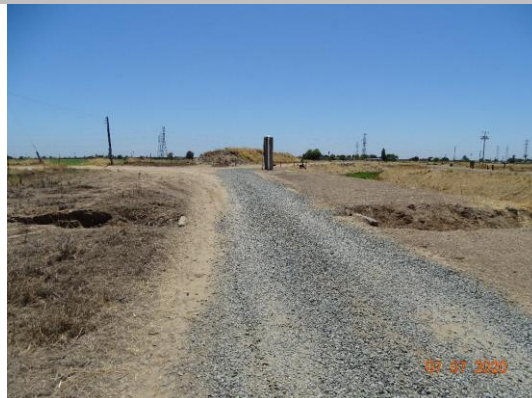
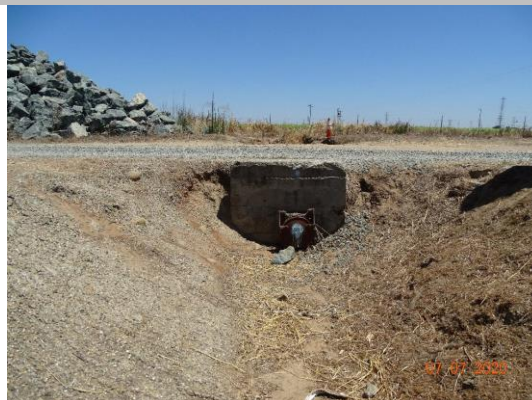
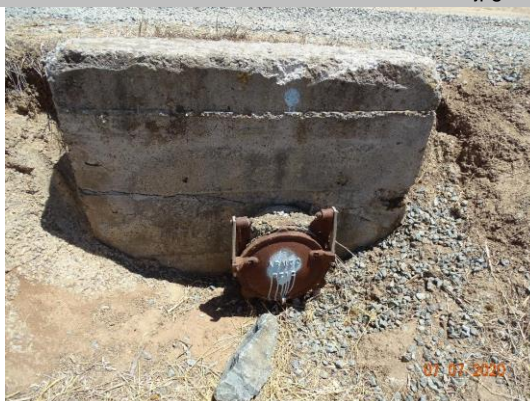
Photo 1 of 3 : UCIP_FA_2020_59630_87211.jpg

Comment Code						
Inspector Comment						
DS_ID:23915 FS_ID:59630 EP_NO: N/A Repair Type: Non-Urgent EVAL Issue: Unauthorized Encroachment, installed decades prior Crossing Status: Found UCIP Comments: 07/07/2020 Crossing evaluated as "Non-Urgent" because there was no permit found authorizing this pipe. Inlet partially blocked with sediment. (A. McDonald - DWR UCIP) FIELD_STRUCT_DESC: 12-inch corrugated metal drainage pipe through the levee, 2 feet below the crown. Flap gate on the waterside (WS) end. Cobble grouted spillway. Cobble grouted intake on the landside (LS). [Additional Reference(s): DWR Levee Log, 1978. USACE San Joaquin O&M Manual 612.2, 1967, (HLM 2.72)]. FS Date: 7/7/2020

Overview of levee crown looking d/s.

View of pipe outlet, flap gate, and headwall located at the WS levee toe.

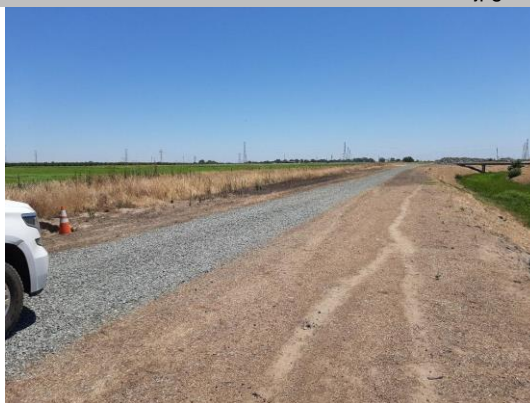
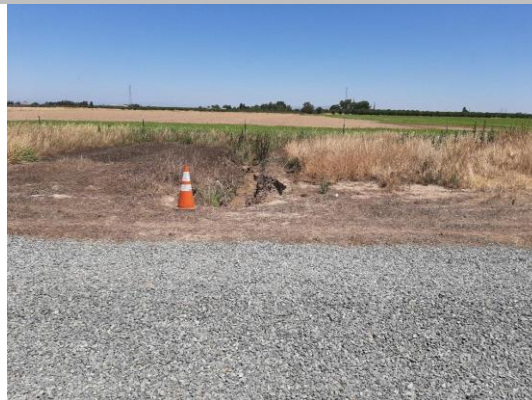
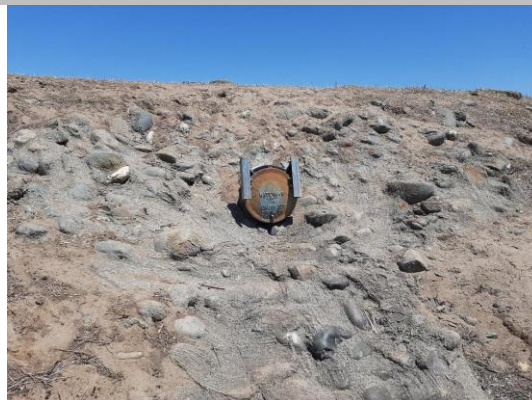
Photo 1 of 3 : UCIP_FA_2020_59632_87220.jpg

DS_ID:23916
 FS_ID:59632
 EP_NO: N/A
 Repair Type: No Action Needed
 EVAL Issue: Compliant
 Crossing Status: Found
 UCIP Comments: 07/03/2020 Crossing evaluated as "No Action Needed." Permit and inspection requirements have been met. (A. McDonald - DWR UCIP)
 FIELD_STRUCT_DESC: 12-inch corrugated metal drainage pipe through the levee, 3 feet below the crown. Flap gate on the waterside (WS) end. Cobble grouted spillway. (Positive closure device installed on intake end under Permit No. 17426, 2003 - Western Dairy Design Associates, Inc.). [Additional Reference(s): DWR Levee Log, 1978. USACE San Joaquin O&M Manual 612.2, 1967, (HLM 2.95)].
 FS Date: 7/3/2020

Overview of levee crown looking d/s.

Overview of the LS and pipe inlet location.

View of pipe outlet, flap gate, and splash apron located at the WS levee toe.

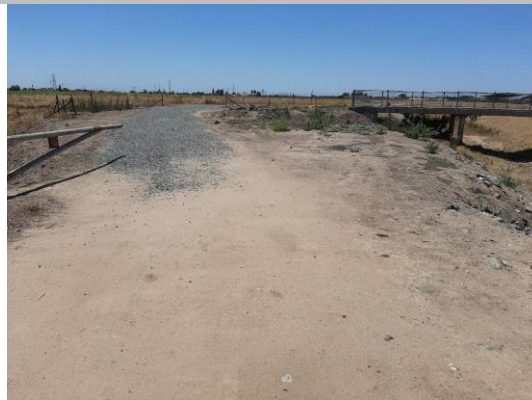
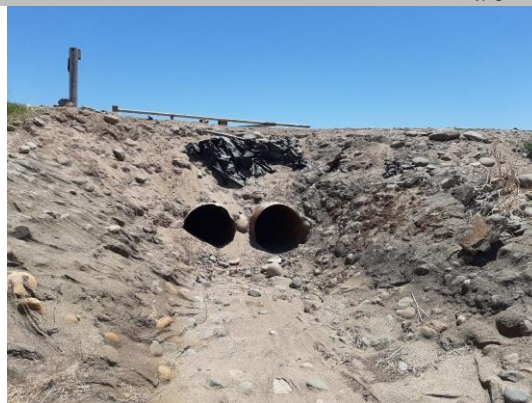
Photo 1 of 3 : UCIP_FA_2020_59674_87230.jpg

Comment Code						
Inspector Comment						
DS_ID:23928 FS_ID:59674 EP_NO: N/A Repair Type: Urgent EVAL Issue: Pipe Integrity Crossing Status: Found UCIP Comments: 07/03/2020 Crossing evaluated as "Urgent" because of a badly deteriorated drainage pipe that is also open on both ends. There was no permit found authorizing this pipe, either. (A. McDonald - DWR UCIP)11/12/2018 NA0017 found corrosion and holes along the bottom of this CMP drainage culvert. Culvert is also open on both ends. Crossing escalated to "Urgent" due to the extensive corrosion that was found. Internal inspection and/or rehabilitation recommended. (A. McDonald - DWR UCIP)Pipe open on both ends. FIELD_STRUCT_DESC: 1 of 2: 24-inch corrugated metal drainage pipe through the levee, 3 feet below the crown. No closure device or flap gate. [Additional Reference(s): USACE San Joaquin O&M Manual 612.2, 1967, (HLM 3.15)]. FS Date: 7/3/2020

Overview of levee crown looking d/s.

View of two drainage pipe outlets located at the WS levee toe.

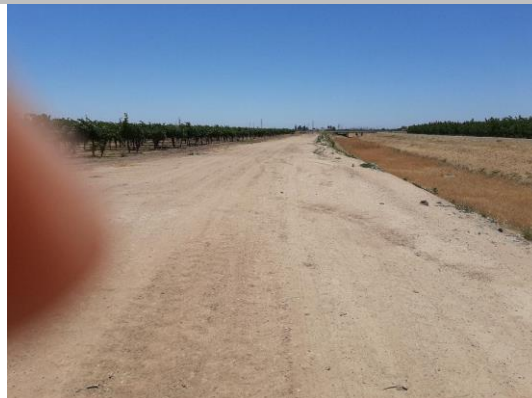
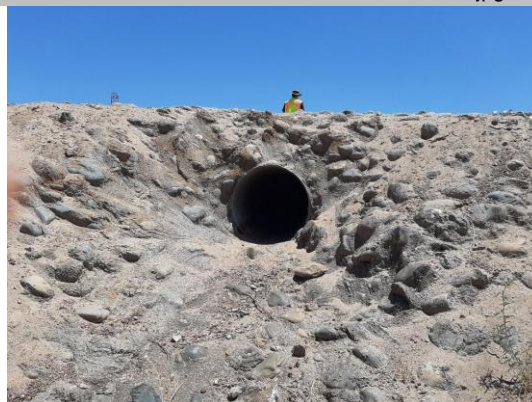
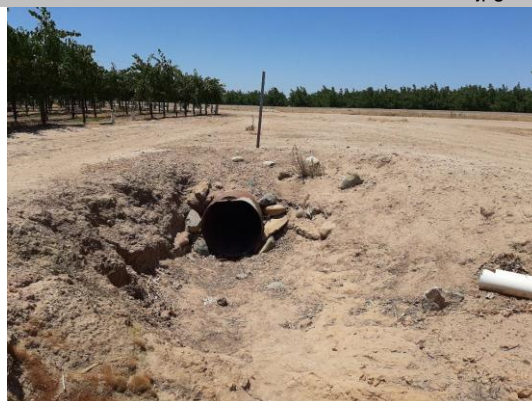
Photo 1 of 3 : UCIP_FA_2020_59676_87247.jpg

Comment Code					
Inspector Comment					
DS_ID:23917 FS_ID:59676 EP_NO: N/A Repair Type: Urgent EVAL Issue: Flood Risk Crossing Status: Found UCIP Comments: 07/03/2020 Crossing evaluated as "Urgent" because it is a straight-through drainage pipe with no flap gate on the WS end. There was also no permit found authorizing this pipe. (A. McDonald - DWR UCIP)No flap gate FIELD_STRUCT_DESC: 24-inch corrugated metal drainage pipe through the levee, 4.5 feet below the crown. Cobble grouted spillway. Cobble grouted intake on the landside (LS). [Additional Reference(s): DWR Levee Log, 1978. USACE San Joaquin O&M Manual 612.2, 1967, (HLM 3.25)]. FS Date: 7/3/2020

Overview of levee crown looking d/s.

View of pipe outlet and splash apron located at the WS levee toe.

View of pipe inlet located 50 to 100 feet off the LS levee toe.

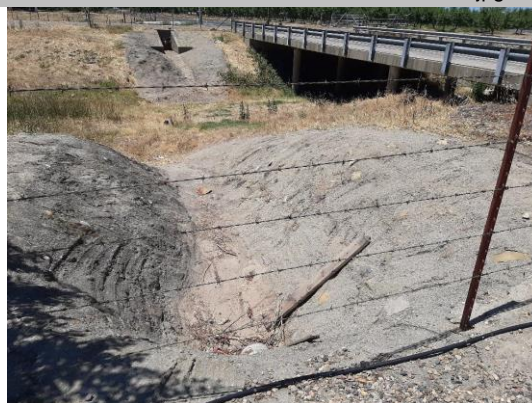
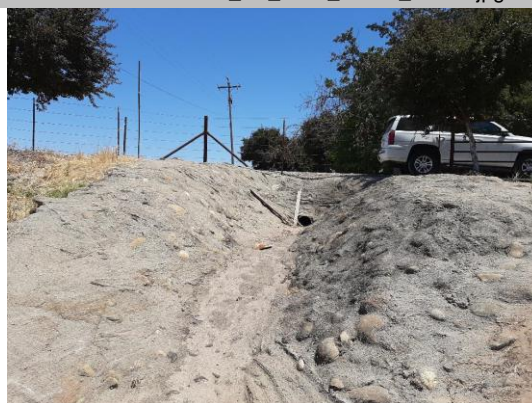
Photo 1 of 3 : UCIP_FA_2020_59638_87257.jpg

DS_ID:23920
 FS_ID:59638
 EP_NO: N/A
 Repair Type: Non-Urgent
 EVAL Issue: Unauthorized Encroachment, installed decades prior
 Crossing Status: Found
 UCIP Comments: 07/03/2020 Crossing evaluated as "Non-Urgent" because there was no permit found authorizing this pipe. Video inspection performed on 04-22-2020. (A. McDonald - DWR UCIP)
 FIELD_STRUCT_DESC: 12-inch corrugated metal drainage pipe through the levee, 4.5 feet below the crown. Cobble grouted spillway.
 [Additional Reference(s): DWR Levee Log, 1978. USACE San Joaquin O&M Manual 612.2, 1967, (HLM 3.52)].
 FS Date: 7/3/2020

Overview of levee crown looking d/s.

View of WS channel and splash apron.

View of pipe outlet and splash apron located at the WS levee toe.

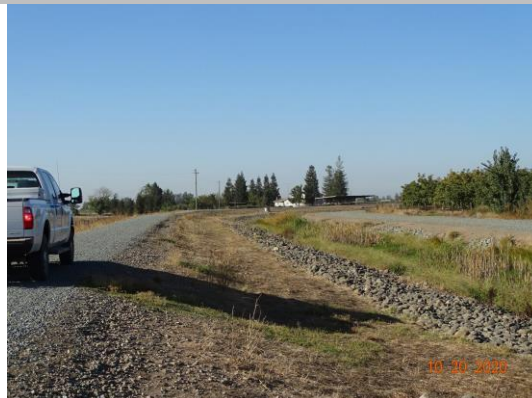
Photo 1 of 1 : FA_2020_NA0017_157_12_20201020_00030.jpg

LM Start	0.00	Rating **	A	Issue No.	12
LM End	0.54	Issue Type +	Ma	Location *	WS
Category	Earthen Levee			GPS Latitude/Longitude	
				Start	End
Item	Vegetation			38.109355 °	38.110832 °
				-121.160448 °	-121.151129 °
DWR ID	DWR_NA0017_13_f_2020_12				
Comment Code					
V1 : Control annual grass and weeds on the levee slopes and easements.					
Inspector Comment					
Vegetation is well maintained in this section.

View of well maintained vegetation on waterside slope. Fall 2020

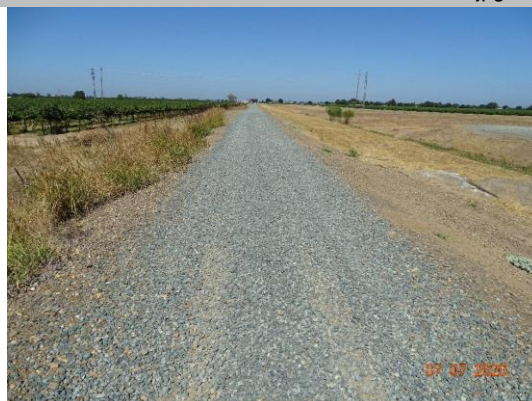
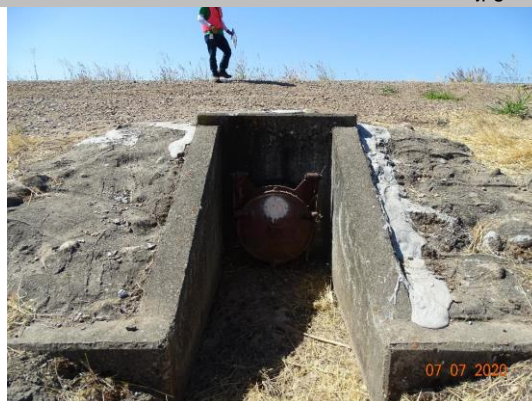
Photo 1 of 3 : UCIP_FA_2020_58900_86685.jpg

Comment Code						
Inspector Comment						
DS_ID:23931 FS_ID:58900 EP_NO: N/A Repair Type: Non-Urgent EVAL Issue: Crossing Status: Found UCIP Comments: 07/07/2020 Record upgraded from No Action Needed to Non Urgent because no permit has been identified authorizing pipe. This is s system feature without any modification to system. Same observation as last inspection. Pipe is in good condition. Video Inspection was performed in 4/24/2020 and the result will be appended to this report when it becomes available. (S.Donovan - DWR UCIP) FIELD_STRUCT_DESC: 24-inch corrugated metal drainage pipe through the levee, 5.5 feet below the crown. Concrete U-shaped headwall on both ends. Flap gate on the waterside (WS) end. [Additional Reference(s): DWR Levee Log, 1978. USACE San Joaquin O&M Manual 612.2, 1967, (HLM 0.03)]. FS Date: 7/7/2020

Top of Levee: View of levee crown looking downstream

Water-Side: View of pipe, headwall, and flapgate.

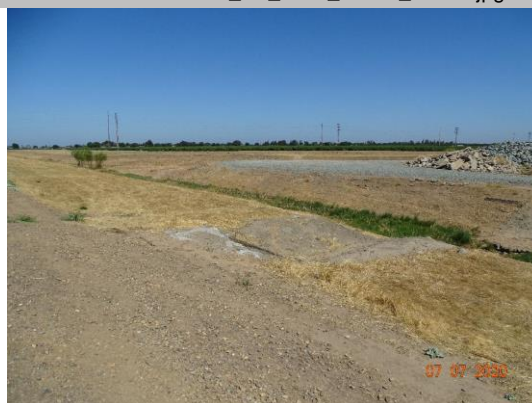
Photo 3 of 3 : UCIP_FA_2020_58900_86687.jpg

Water-Side: View of headwall, spillway and channel.

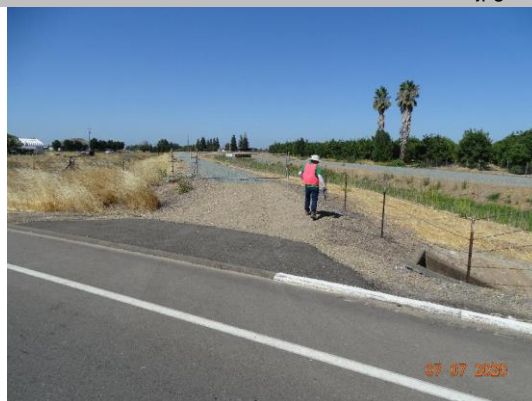
Photo 1 of 3 : UCIP_FA_2020_58902_86734.jpg

Comment Code						
Inspector Comment						
DS_ID:23933 FS_ID:58902 EP_NO: N/A Repair Type: Non-Urgent EVAL Issue: Crossing Status: Found UCIP Comments: 07/07/2020 Record updated from No Action Needed to Non-Urgent. No permit has been identified authorizing pipe. Pipe was in good condition, same as last inspection. Internal video Inspection was performed on 2/21/2020 (S.Donovan - DWR UCIP) FIELD_STRUCT_DESC: 24-inch corrugated metal drainage pipe through the levee, 5 feet below the crown. Concrete U-shaped headwall on both ends. Flap gate on the waterside (WS) end. Cobble grouted spillway. Cobble grouted intake on the landside (LS). [Additional Reference(s): DWR Levee Log, 1978. USACE San Joaquin O&M Manual 612.2, 1967, (HLM 0.58)]. FS Date: 7/7/2020 1:09:28 PM

Top of Levee: View of levee crown looking downstream

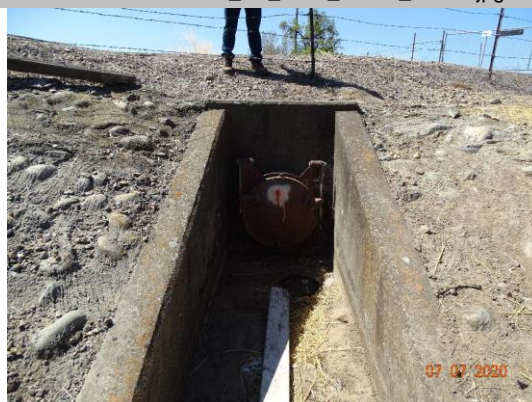
Photo 2 of 3 : UCIP_FA_2020_58902_86735.jpg

Water-Side: View of pipe, headwall and flapgate.

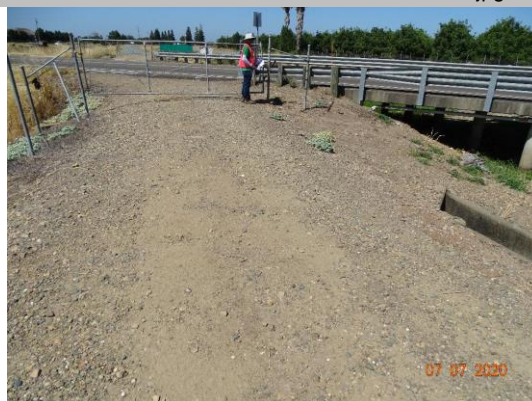
Photo 2 of 3 : UCIP_FA_2020_58905_86743.jpg

Overview of Levee: View of levee crown looking downstream.

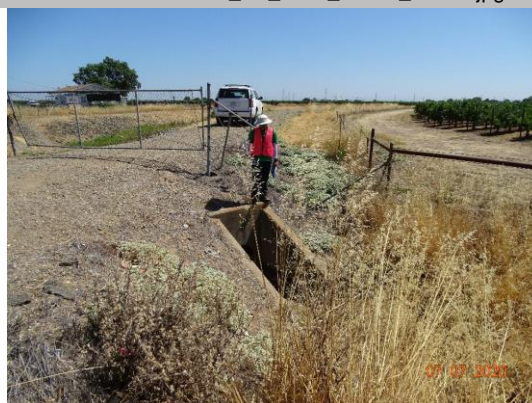
Photo 3 of 3 : UCIP_FA_2020_58905_86742.jpg

Land-Side: view of pipe, headwall and levee crown.

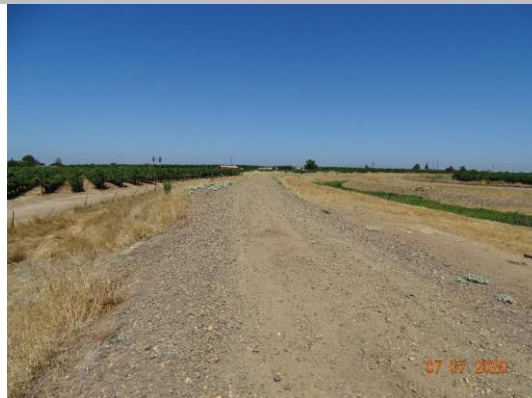
Photo 1 of 3 : UCIP_FA_2020_58906_86746.jpg

Comment Code						
Inspector Comment						
DS_ID:23935 FS_ID:58906 EP_NO: N/A Repair Type: Non-Urgent EVAL Issue: Crossing Status: Found UCIP Comments: 07/07/2020 Record updated from No Action Needed to Non Urgent. No permit has been identified authorizing pipe. This is a system feature without any modification to the system. Pipe is in good condition. Same observation as last inspection. Internal video inspection was performed in 4/24/2020. (S.Donovan - DWR UCIP) FIELD_STRUCT_DESC: 24-inch corrugated metal drainage pipe through the levee, 5 feet below the crown. Concrete U-shaped headwall on both ends. Flap gate on the waterside (WS) end. Cobble grouted spillway. Cobble grouted intake on the landside (LS). [Additional Reference(s): DWR Levee Log, 1978. USACE San Joaquin O&M Manual 612.2, 1967, (HLM 0.91)]. FS Date: 7/7/2020 1:14:37 PM

Overview of Levee: View of levee crown looking downstream.

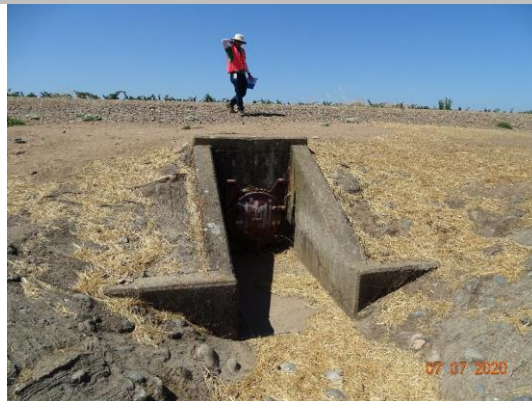
Photo 2 of 3 : UCIP_FA_2020_58906_86747.jpg

Water-Side: view of pipe, headwall, and flapgate.

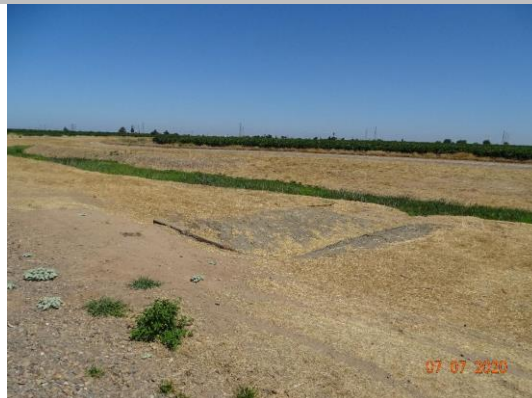
Photo 3 of 3 : UCIP_FA_2020_58906_86748.jpg

Water-Side: view of headwall and spillway to channel

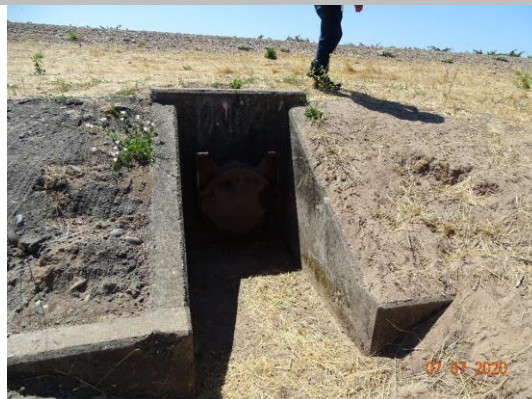
Photo 1 of 3 : UCIP_FA_2020_58907_86752.jpg

DS_ID:23936
FS_ID:58907
EP_NO: N/A
Repair Type: Non-Urgent
EVAL Issue:
Crossing Status: Found
UCIP Comments: 07/07/2020 Record updated from No Action Needed to Non Urgent. No permit has been identified authorizing pipe. This is a system feature without any modification to the pipe. Pipe is in good condition. Same observation as last inspection. (S.Donovan - DWR UCIP)
FIELD_STRUCT_DESC: 24-inch corrugated metal drainage pipe through the levee, 6.5 feet below the crown. Concrete U-shaped headwall on both ends. Flap gate on the waterside (WS) end. Cobble grouted spillway. Cobble grouted intake on the landside (LS).
[Additional Reference(s): DWR Levee Log, 1978. USACE San Joaquin O&M Manual 612.2, 1967, (HLM 1.11)].
FS Date: 7/7/2020 1:15:26 PM

Water-Side: view of pipe with headwall and flapgate.

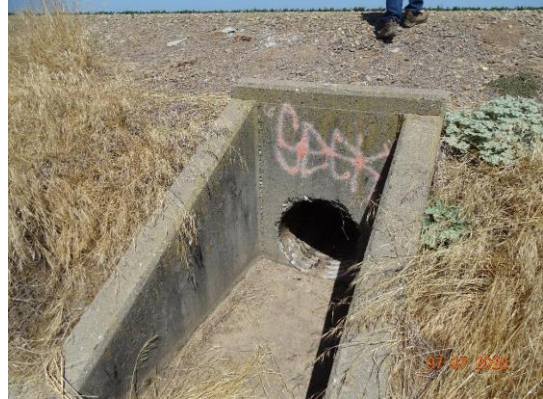
Photo 2 of 3 : UCIP_FA_2020_58907_86750.jpg

Land-Side: view of pipe and headwall.

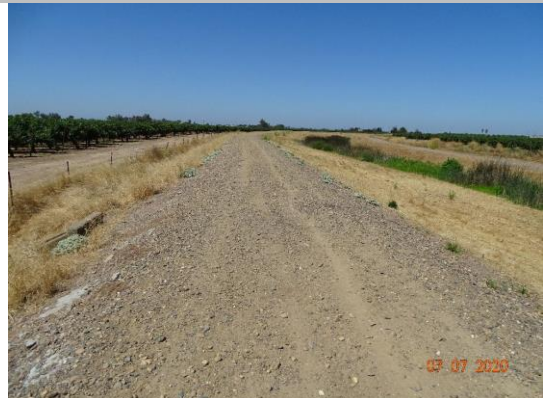
Photo 3 of 3 : UCIP_FA_2020_58907_86751.jpg

Overview of Levee: View of levee crown looking downstream.

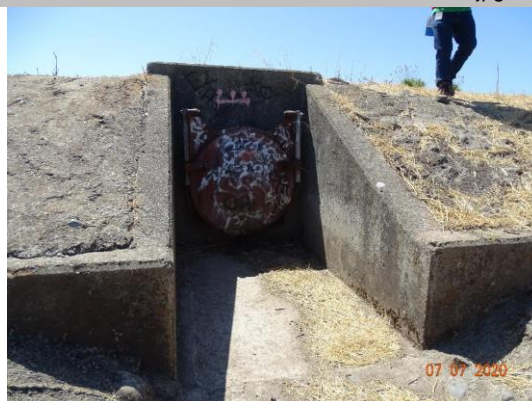
Photo 1 of 3 : UCIP_FA_2020_58908_86755.jpg

Comment Code						
Inspector Comment						
DS_ID:23937 FS_ID:58908 EP_NO: N/A Repair Type: Non-Urgent EVAL Issue: Crossing Status: Found UCIP Comments: 07/07/2020 Record updated from No Action Needed to Non URgent. No permit has been identified authorizing pipe. This is a system feature without any modification to the system. Pipe is in good condition. Same observation as last inspection. (S.Donovan - DWR UCIP) FIELD_STRUCT_DESC: 36-inch corrugated metal drainage pipe through the levee, 4 feet below the crown. Concrete U-shaped headwall on both ends. Flap gate on the waterside (WS) end. Cobble grouted spillway. Cobble grouted intake on the landside (LS). [Additional Reference(s): DWR Levee Log, 1978. USACE San Joaquin O&M Manual 612.2, 1967, (HLM 1.18)]. FS Date: 7/7/2020 1:16:27 PM

Water-Side: view of pipe with headwall and flapgate.

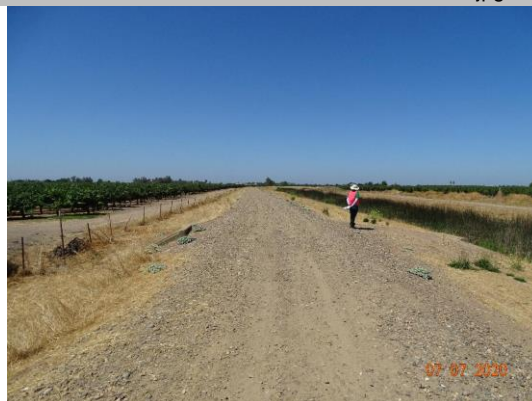
Photo 2 of 3 : UCIP_FA_2020_58908_86754.jpg

Overview of Levee: View of levee crown looking downstream.

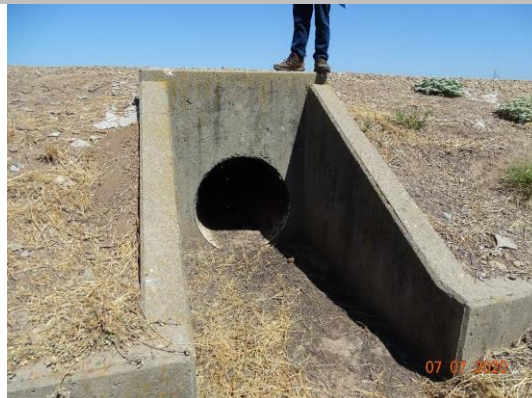
Photo 3 of 3 : UCIP_FA_2020_58908_86753.jpg

Land-Side: view of pipe and headwall.

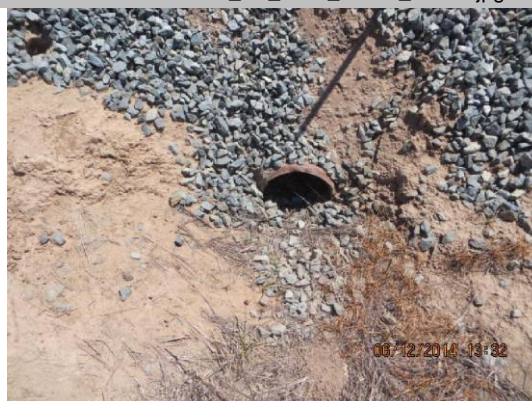
Pipe at inlet on LS shoulder.

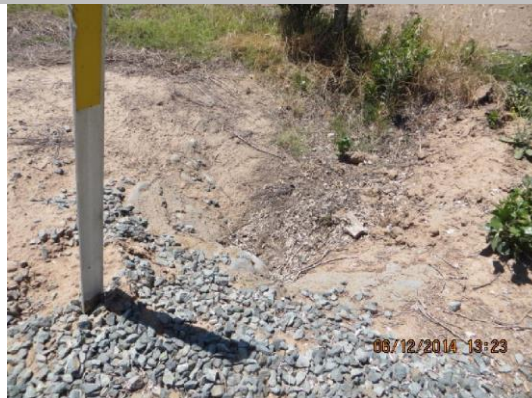
Photo 2 of 3 : UCIP_FA_2020_38613_70770.jpg

Inlet on LS shoulder.

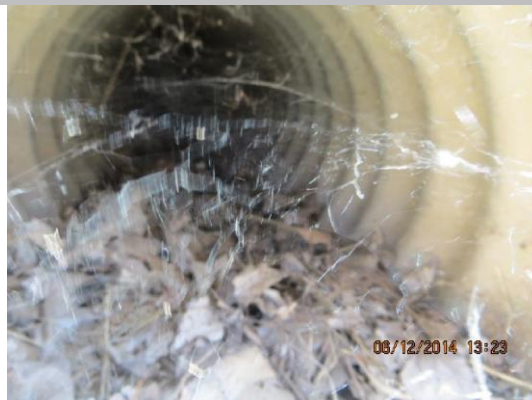
Photo 3 of 3 : UCIP_FA_2020_38613_70769.jpg

Inside pipe at LS shoulder.

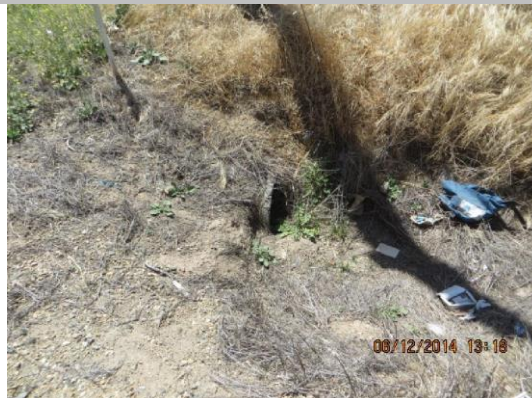
Photo 1 of 3 : UCIP_FA_2020_53502_70768.jpg

Comment Code						
Inspector Comment						
DS_ID:23943						
FS_ID:53502						
EP_NO: N/A						
Repair Type: Non-Urgent						
EVAL Issue:						
Crossing Status: Found						
UCIP Comments: 09/18/2018 Pipe is close to the crown. It may not create a serious situation. Maintenance required by owner at pipe inlet. Crossing downgraded to "Non-Urgent." (A. McDonald - DWR UCIP)11/04/2016 Same as previous inspection. Crossing remains Urgent crossing, open on both ends. (O. Magana - DWR UCIP)06/12/2014 Pipe inlet and outlet partially blocked by sediment. No flapgate. (W. Wylie - DWR UCIP)						
FIELD_STRUCT_DESC: 18-inch corrugated metal drainage pipe through the levee, 2.5 feet below the crown. Pipe open on both ends. Inlet is located at the end of a drainage ditch along the road. Cobble grouted spillway on the waterside (WS). [Additional Reference(s): DWR Levee Log, 1977, 1978, 1987, 1990. USACE San Joaquin O&M Manual Unit 612, Part No. 2 - Bear Creel Project, Unit 7: HLM 7.19 – 16.77, Unit 8: HLM 7.55-16.48, Unit 9: HLM 0.10-1.52; Unit 10: HLM 0.03-1.35, Unit 11: HLM 0.16-3.55, Unit 12: HLM 0.14-3.91; Unit 13, HLM 0.03-1.18; Unit 14, HLM 0.02-1.17, 1967, (HLM 0.55)].

Pipe on LS toe.

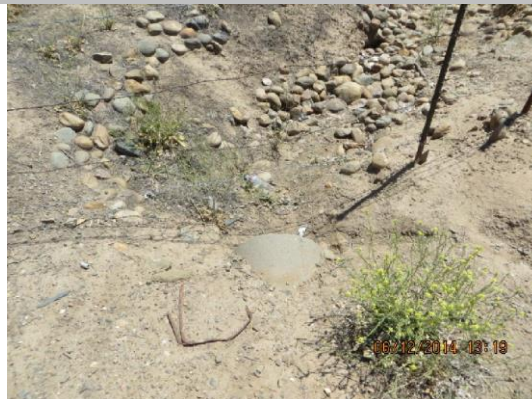
Photo 2 of 3 : UCIP_FA_2020_53502_70767.jpg

Pipe on WS shoulder.

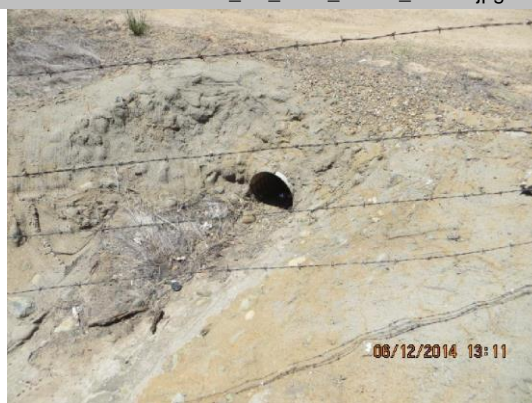
Photo 1 of 3 : UCIP_FA_2020_38610_70764.jpg

DS_ID:23944
 FS_ID:38610
 EP_NO: N/A
 Repair Type: No Action Needed
 EVAL Issue:
 Crossing Status: Found
 UCIP Comments:
 FIELD_STRUCT_DESC: 18-inch corrugated metal drainage pipe under the road, 2.5 feet below the crown. Open on both ends. Cobble grouted spillway. Cobble grouted intake on the landside (LS). [Additional Reference(s): DWR Levee Log, 1978. USACE San Joaquin O&M Manual 612.2, 1967, (HLM 0.57)].
 FS Date: 6/12/2014

Pipe and grouted spillway on WS

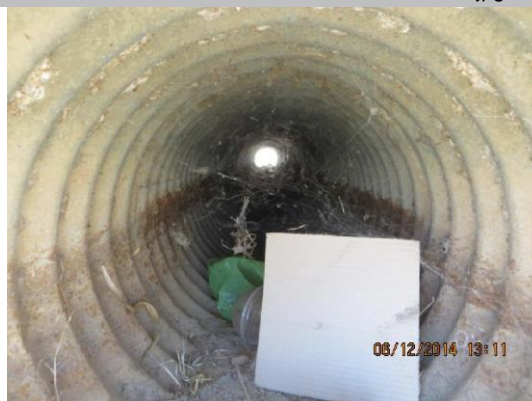
Photo 2 of 3 : UCIP_FA_2020_38610_70763.jpg

Inside pipe at LS toe.

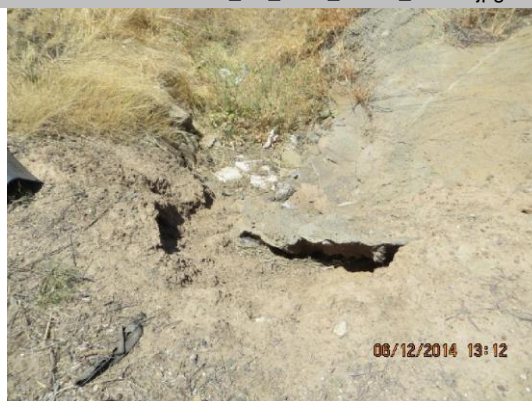
Photo 3 of 3 : UCIP_FA_2020_38610_70762.jpg

Pipe at LS toe.

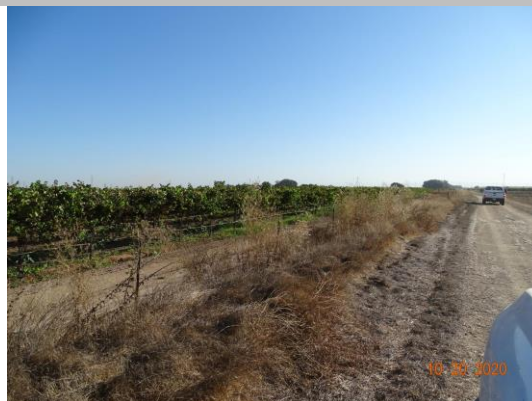
Photo 1 of 1 : FA_2020_NA0017_158_21_20201020_00045.jpg

LM Start	0.57	Rating **	M	Issue No.	21
LM End	1.10	Issue Type +	Ma	Location *	LS
Category	Earthen Levee			GPS Latitude/Longitude	
				Start	End
Item	Vegetation			38.111538 °	38.112091 °
				-121.150685 °	-121.142641 °
DWR ID	DWR_NA0017_14_f_2020_21				
Comment Code					
V1 : Control annual grass and weeds on the levee slopes and easements.					
Inspector Comment

View of tall vegetation on landside slope. Fall 2020

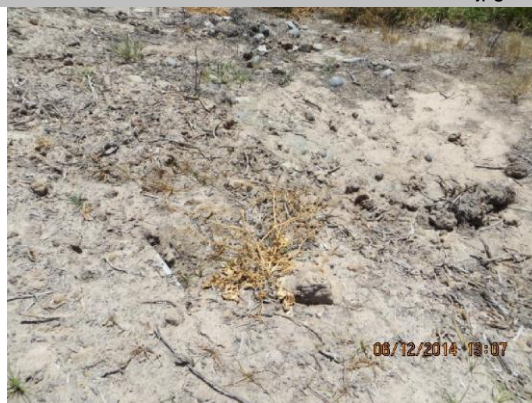
Photo 1 of 3 : UCIP_FA_2020_41365_70758.jpg

LM Start	0.75	Rating **	M	Issue No.	31
LM End	0.75	Issue Type +	Ma	Location *	
Category	Supplemental			GPS Latitude/Longitude	
				Start	End
Item	DWR UCIP LMA Responsibility			38.111475 °	38.111475 °
				-121.148081 °	-121.148081 °
DWR ID	23945				
Comment Code					
Inspector Comment					
DS_ID:23945 FS_ID:41365 EP_NO: N/A Repair Type: Non-Urgent EVAL Issue: Crossing Status: Found UCIP Comments: Pipe open on both ends. Levee appears abandoned. FIELD_STRUCT_DESC: 24-inch corrugated metal drainage pipe through the levee, 1 foot below the crown. Cobble grouted spillway. Cobble grouted intake on the landside (LS). Open on both ends. [Additional Reference(s): DWR Levee Log, 1978. USACE San Joaquin O&M Manual 612.2, 1967, (HLM 0.76)]. FS Date: 6/12/2014

Pipe on WS slope.

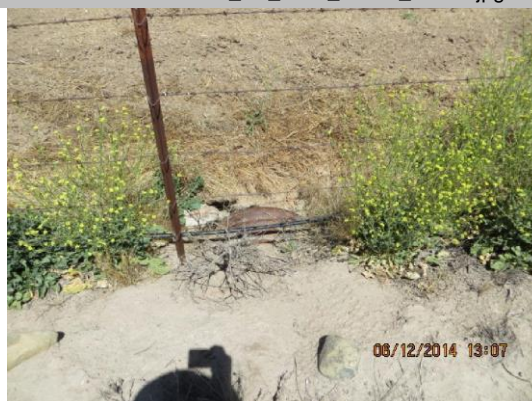
Photo 3 of 3 : UCIP_FA_2020_41365_70756.jpg

Pipe on LS shoulder.

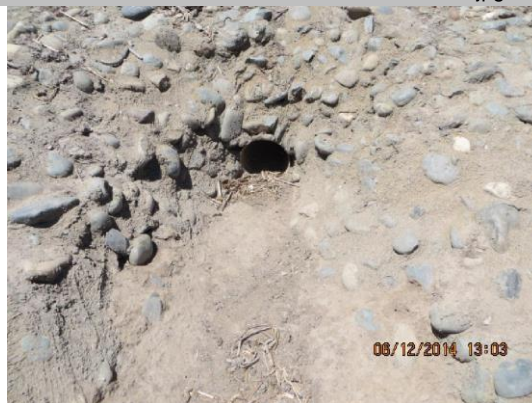
Photo 2 of 3 : UCIP_FA_2020_41791_70754.jpg

Pipe and grouted spillway on WS slope.

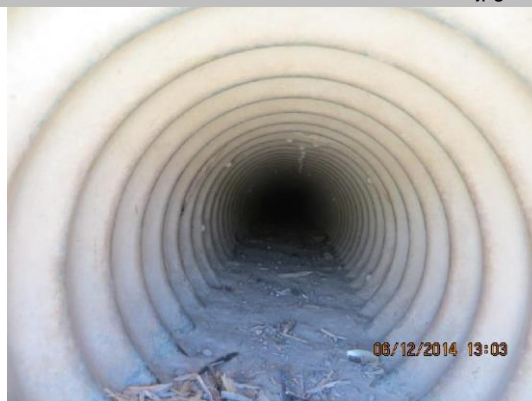
Photo 3 of 3 : UCIP_FA_2020_41791_70753.jpg

Inside pipe at WS slope.

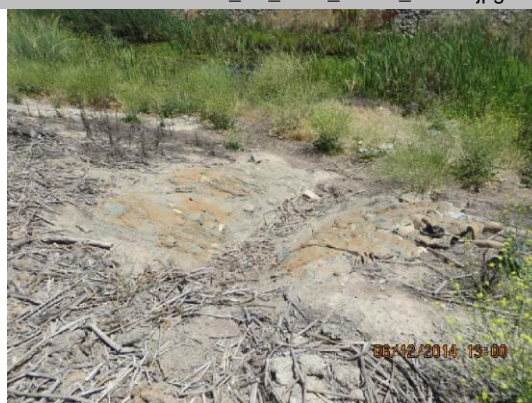
Photo 1 of 2 : UCIP_FA_2020_41792_70752.jpg

DS_ID:23947
 FS_ID:41792
 EP_NO: N/A
 Repair Type: Non-Urgent
 EVAL Issue:
 Crossing Status: Found
 UCIP Comments: Pipe buried on LS shoulder and open on WS.
 Levee appears abandoned.
 FIELD_STRUCT_DESC: *ABANDONED* 18-inch corrugated metal drainage pipe through the levee, 3 feet below the crown. Open on both ends. Cobble grouted spillway. Cobble grouted intake on the landside (LS). [Additional Reference(s): DWR Levee Log, 1978. USACE San Joaquin O&M Manual 612.2, 1967, (HLM 0.97)].
 FS Date: 6/12/2014

Pipe and grouted spillway on WS slope.

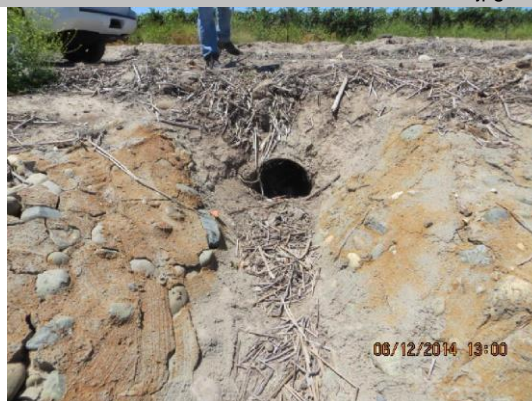
Photo 2 of 2 : UCIP_FA_2020_41792_70751.jpg

Pipe and grouted spillway on WS slope.
