**Flood Control Project Maintenance
Levee Inspections**

Maintenance Issue Types Only, Levee Inspection Report By Mile - Fall 2020

San Joaquin County Flood Control and Water Conservation District

Waterway	Bank	Unit Miles	Inspection Start/End	Inspector
Unit No. 01 Littlejohn Creek	Left	2.59	10/20/2020 10/20/2020	Alberto De Leon

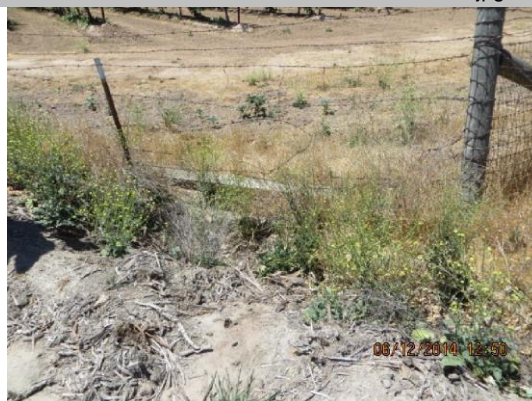
Photo 1 of 3 : UCIP_FA_2020_41793_70746.jpg

DS_ID:23949
 FS_ID:41793
 EP_NO: N/A
 Repair Type: Non-Urgent
 EVAL Issue:
 Crossing Status: Found
 UCIP Comments: Pipe appears abandoned. Levee appears Abandoned.
 FIELD_STRUCT_DESC: *ABANDONED* 12-inch corrugated metal drainage pipe through the levee, 2.5 feet below the crown. Flap gate on the waterside (WS) end. Cobble grouted spillway. Cobble grouted intake on the landside (LS). [Additional Reference(s): DWR Levee Log, 1978. USACE San Joaquin O&M Manual 612.2, 1967, (HLM 1.12)].
 FS Date: 6/12/2014

LS of levee at pipe. Pipe largely filled in with soil.

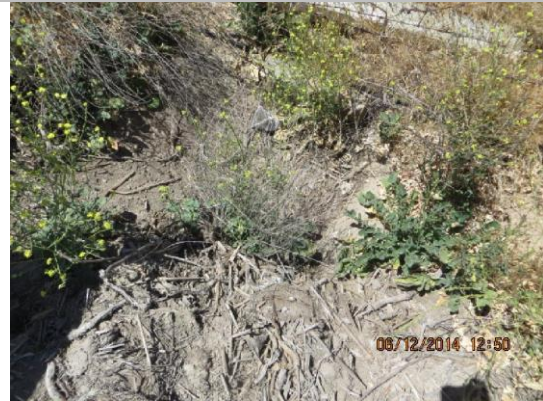
Photo 2 of 3 : UCIP_FA_2020_41793_70745.jpg

LS of levee at pipe. Pipe largely filled in with soil.

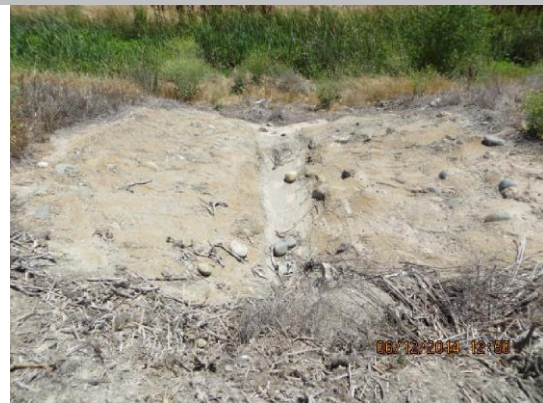
Photo 3 of 3 : UCIP_FA_2020_41793_70744.jpg

Pipe, flapgate, and grouted spillway on WS slope.

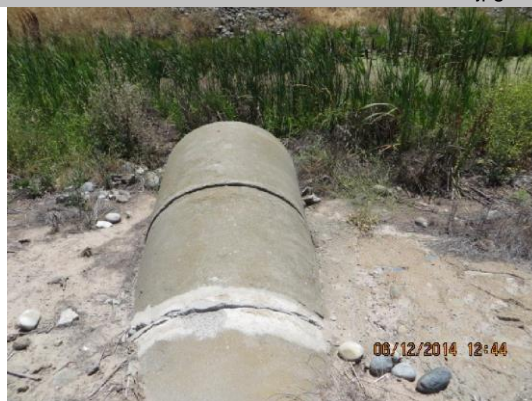
Photo 1 of 3 : UCIP_FA_2020_41794_70742.jpg

LM Start	1.16	Rating **	M	Issue No.	36	
LM End	1.16	Issue Type +	Ma	Location *		
Category	Supplemental			GPS Latitude/Longitude		
				Start	End	
Item	DWR UCIP LMA Responsibility			38.112296 °	38.112296 °	
				-121.141654 °	-121.141654 °	
DWR ID	23950					
Comment Code						
Inspector Comment						
DS_ID:23950 FS_ID:41794 EP_NO: N/A Repair Type: Non-Urgent EVAL Issue: Crossing Status: Found UCIP Comments: Pipe open on both ends. Levee appears abandoned. FIELD_STRUCT_DESC: 48-inch reinforced concrete drainage pipe through the levee, 5.5 feet below the crown. Cobble grouted spillway. Cobble grouted intake on the landside (LS). Open on both ends. [Additional Reference(s): DWR Levee Log, 1978. USACE San Joaquin O&M Manual 612.2, 1967, (HLM 1.17)]. FS Date: 6/12/2014

Pipe on WS toe.

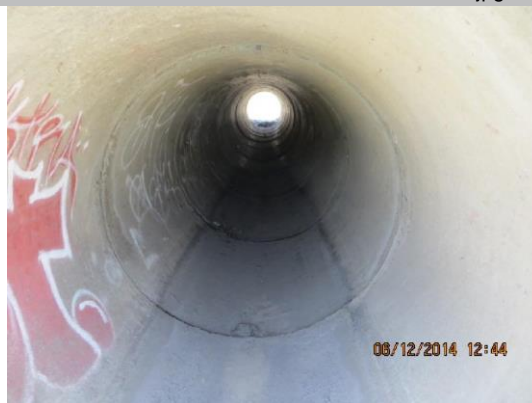
Photo 2 of 3 : UCIP_FA_2020_41794_70741.jpg

Inside pipe.

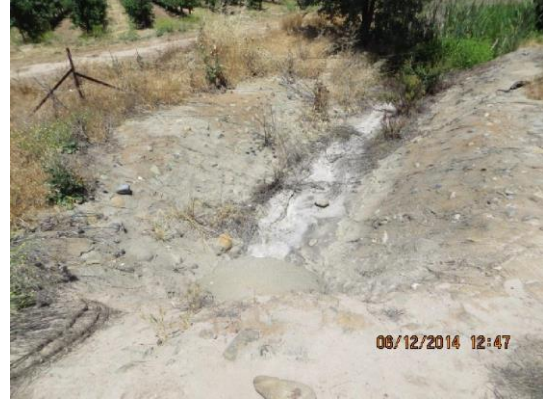
Photo 3 of 3 : UCIP_FA_2020_41794_70740.jpg

Pipe at LS intake.

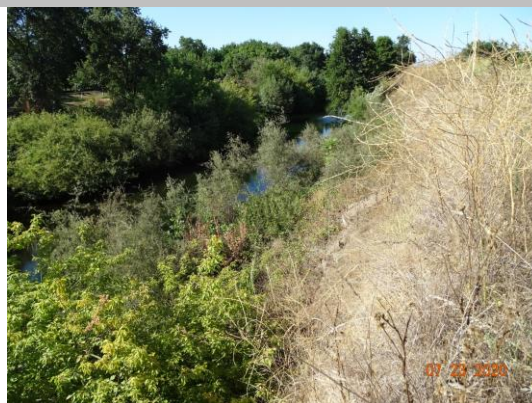
Photo 1 of 2 : SJR2019_NA0017U15RM22.91_02.JPG

Comment Code					
Inspector Comment					
Site ID: NA0017U15RM22.91					
07/23/2020: New erosion visible in some locations. The area is densely vegetated.					
08/28/2019: From 2011 to 2019, no significant changes were observed during the annual survey.					
11/02/2010: The mile-long erosion continues to degrade the bank.					
There are a few trees along the mile-long stretch on the lower bank slope that are affected by the scarp. WS Levee Slope was changed to 2:1. As a result, normalized score increased from 62 to 65.					
08/05/2010: Recommended for waterside repair, per CLRO; "water velocity is a major factor for accelerating bank slope erosion."					
8/12/2009: Near-vertical bank erosion; degrading channel is incising the banks; recommend annual assessment and monitoring of critical erosion site, per CLRO CES Evaluation 2008 Report; district is monitoring site for change in condition; site was previously rated "U".

2007: Visited site 02/06/2007; possible critical site.

7/23/2020: View of the erosion looking downstream.

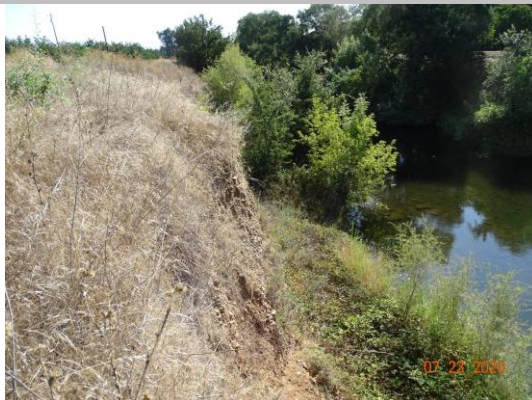
Photo 2 of 2 : SJR2019_NA0017U15RM22.91_04.JPG

7/23/2020: Close-up view of the erosion looking upstream.

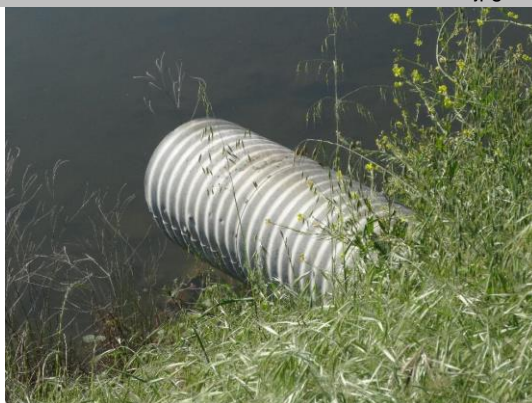
Photo 1 of 2 : UCIP_FA_2020_34877_62779.jpg

DS_ID:23199
 FS_ID:34877
 EP_NO: N/A
 Repair Type: Non-Urgent
 EVAL Issue:
 Crossing Status: Found
 UCIP Comments: Deformed inlet opening. Needs cleaning and clearing on inlet opening on landside.
 FIELD_STRUCT_DESC: 18-inch corrugated metal drainage pipe through the levee, 4.5 feet below the crown. Grouted spillway on the waterside (WS) end. Open on both ends. [Additional Reference(s): DWR Levee Log, 1992. USACE San Joaquin O&M Manual 611.1, Volume F, (HLM 1.18)].
 FS Date: 4/9/2014

WS view: CM outfall pipe on channel bank.

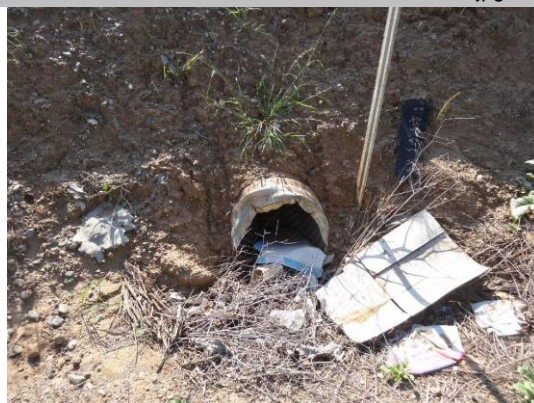
Photo 2 of 2 : UCIP_FA_2020_34877_62778.jpg

LS view: CM inlet pipe. Pipe opening obstructed with debris.

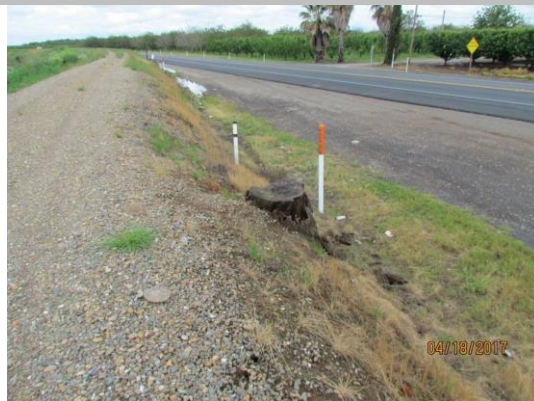
Photo 1 of 1 : FA_2020_NA0017_159_1128_20200901_00082.jpg

LM Start	1.45	Rating **	N	Issue No.	1128	
LM End	1.45	Issue Type +	Ma	Location *	LS	
Category	Earthen Levee			GPS Latitude/Longitude		
				Start		End
Item	Trim / Thin Trees			38.040188 °		38.040188 °
				-121.031854 °		-121.031854 °
DWR ID	DWR_NA0017_15_s_2012_1128					
Comment Code						
T5 : Tree stumps.						
Inspector Comment

View of a tree stump on the landside shoulder of the levee.

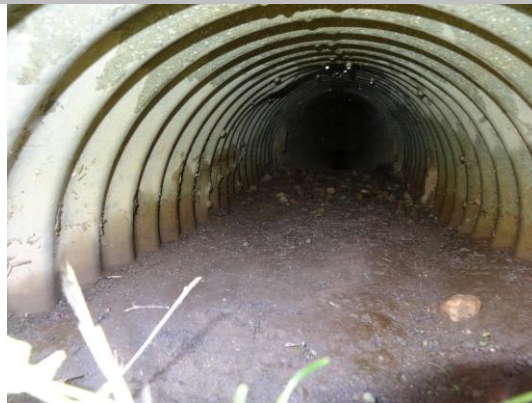
Photo 2 of 3 : UCIP_FA_2020_40369_62784.jpg

WS view: inside view of the outlet pipe. Needs cleaning and clearing.

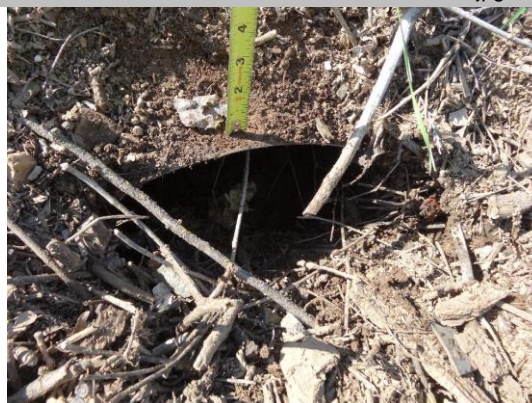
Photo 3 of 3 : UCIP_FA_2020_40369_62783.jpg

LS view: buried inlet pipe. Needs cleaning and clearing.

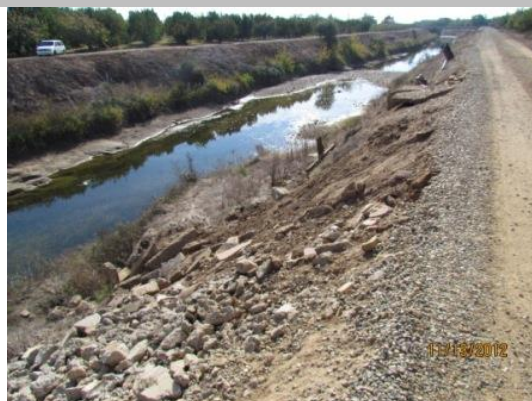
Photo 1 of 1 : FA_2020_NA0017_159_43_20200901_00012.jpg

LM Start	3.78	Rating **	M	Issue No.	43
LM End	3.78	Issue Type +	Ma	Location *	WS
Category	Earthen Levee			GPS Latitude/Longitude	
				Start	End
Item	Slope Stability			38.019119 °	38.019119 °
				-121.064034 °	-121.064034 °
DWR ID	DWR_NA0017_15_f_2012_43				
Comment Code					
S1 : Repair slope instability.					
Inspector Comment

Slope instability on the waterside slope of the levee looking downstream.

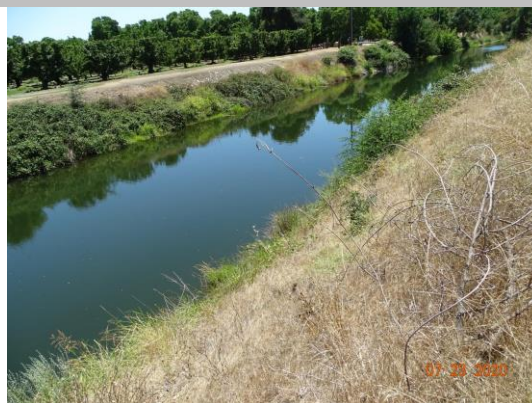
Photo 1 of 2 : SJR2019_DWR_NA0017_15_f_2015_133_02.JPG

LM Start	4.51	Rating **	M	Issue No.	11
LM End	4.51	Issue Type +	Ma	Location *	WS
Category	Supplemental			GPS Latitude/Longitude	
				Start	End
Item	DWR Erosion Survey			38.009753 °	38.009753 °
				-121.069559 °	-121.069559 °
DWR ID	NA0017U15RM18.45				
Comment Code					
Inspector Comment					
Site ID: NA0017U15RM18.45					
07/23/2020: This site was discovered during the DWR Fall 2015 Levee Inspections. Although dense vegetation is limiting the view, the erosion, which extends to the upper levee slope, could still be seen.

7/23/2020: Looking down the levee slope. Dense vegetation is limiting the view of the erosion.

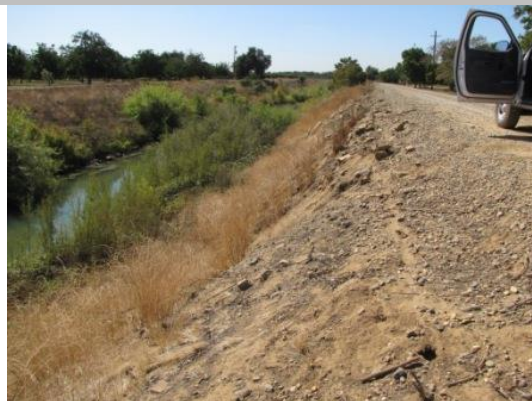
Photo 1 of 1 : FA_2020_NA0017_159_1009_20200901_00075.jpg

LM Start	5.04	Rating **	A/W	Issue No.	1009
LM End	5.04	Issue Type +	Ma	Location *	WS
Category	Earthen Levee			GPS Latitude/Longitude	
				Start	End
Item	Erosion / Bank Caving			38.003021 °	38.003021 °
				-121.073658 °	-121.073658 °
DWR ID	DWR_NA0017_15_s_2012_1009				
Comment Code					
E1 : Note and monitor erosion site.					
Inspector Comment

View of a slip in the waterward levee slope looking downstream.

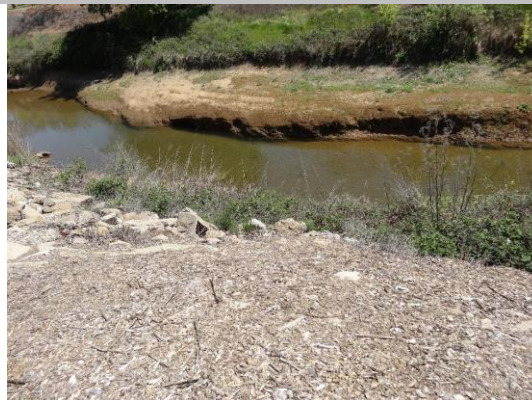
Photo 1 of 2 : UCIP_FA_2020_34924_62867.jpg

LM Start	5.46	Rating **	A/W	Issue No.	1165	
LM End	5.46	Issue Type +	Ma	Location *		
Category	Supplemental			GPS Latitude/Longitude		
				Start		End
Item	DWR UCIP LMA Responsibility			37.997990 °		37.997990 °
				-121.078092 °		-121.078092 °
DWR ID	23308					
Comment Code						
Inspector Comment						
DS_ID:23308						
FS_ID:34924						
EP_NO: N/A						
Repair Type: No Action Needed						
EVAL Issue:						
Crossing Status: Found						
UCIP Comments: Inlet CM pipe riser on landside shoulder. Pipe not found on waterside. Dense vegetation on channel bank. May need inlet cleaning.						
FIELD_STRUCT_DESC: 18-inch corrugated metal drainage pipe, 2 feet below the roadway. Concrete rubble splash apron on the waterside (WS) end. [Additional Reference(s): DWR Levee Log, 1977. USACE San Joaquin O&M Manual 611.1, Volume F, (HLM 5.58)].						
FS Date: 4/9/2014

WS view: no pipe and structure found on waterside. Dense vegetation on channel bank.

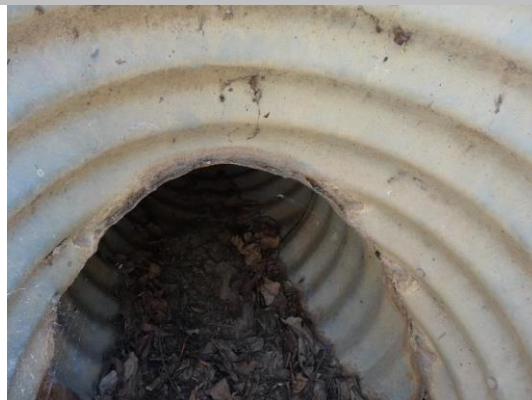
Photo 2 of 2 : UCIP_FA_2020_34924_62866.jpg

LS view: inside view of CMP inlet chamber.

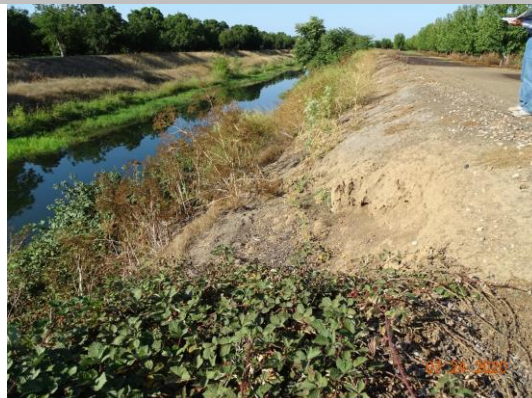
Photo 1 of 3 : SJR2019_NA0017U15RM17.67_02.JPG

LM Start	5.52	Rating **	A/W	Issue No.	5
LM End	5.52	Issue Type +	Ma	Location *	WS
Category	Supplemental			GPS Latitude/Longitude	
				Start	End
Item	DWR Erosion Survey			37.997257 °	37.997257 °
				-121.078775 °	-121.078775 °
DWR ID	NA0017U15RM17.67				
Comment Code					
Inspector Comment					
Site ID: NA0017U15RM17.67					
*This area is patrol road only and therefore the site is not rated					
7/24/2020: Some burrowing activity observed. Site is likely to extend toward downstream during the next rain event.					
08/28/2019: The erosion is located at the upper slope of the channel bank and was likely caused by rainfall runoff.

7/24/2020: View of the erosion looking downstream.

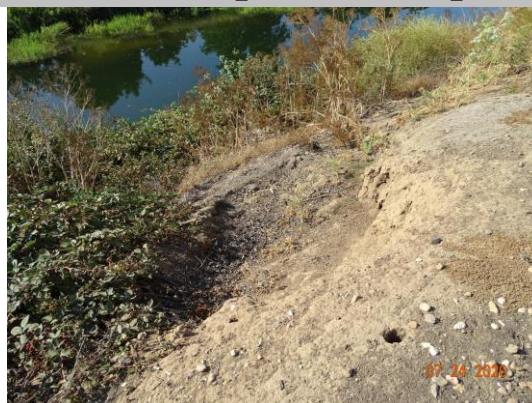
Photo 2 of 3 : SJR2019_NA0017U15RM17.67_03.JPG

7/24/2020: Close-up view of the erosion.

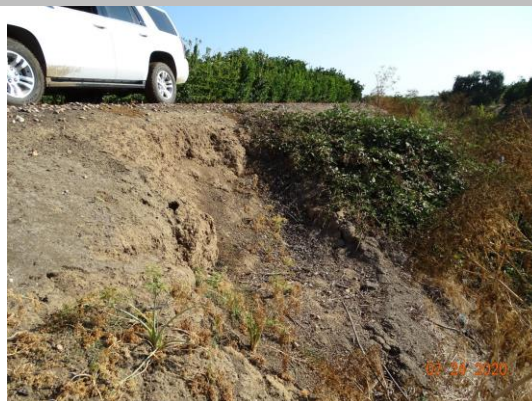
Photo 3 of 3 : SJR2019_NA0017U15RM17.67_05.JPG

7/24/2020: Close-up view of the erosion looking upstream.

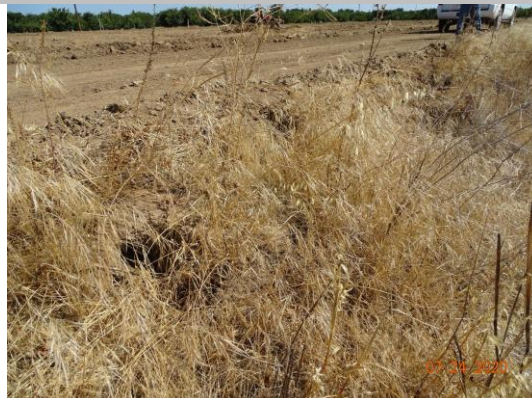
Photo 1 of 3 : SJR2019_DWR_NA0017_15_f_2017_162_02.JPG

LM Start	7.67	Rating **	A/W	Issue No.	14
LM End	7.67	Issue Type +	Ma	Location *	WS
Category	Supplemental			GPS Latitude/Longitude	
				Start	End
Item	DWR Erosion Survey			37.976275 °	37.976275 °
				-121.106364 °	-121.106364 °
DWR ID	NA0017U15RM15.25				
Comment Code					
Inspector Comment					
Site ID: NA0017U15RM15.25					
*This area is patrol road only and therefore the site is not rated					
07/24/2020: This site was discovered during the DWR Fall 2017 Levee					
Inspections. The erosion is caused by surface runoff and likely to cut					
into the patrol road during the next storm events.

7/24/2020: View of the erosion on the upper slope.

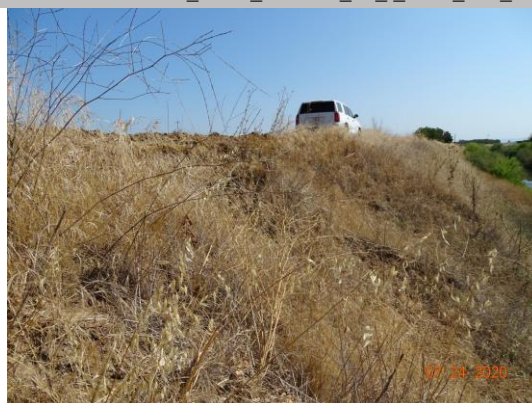
Photo 2 of 3 : SJR2019_DWR_NA0017_15_f_2017_162_03.JPG

7/24/2020: View of the erosion on the upper slope looking upstream.

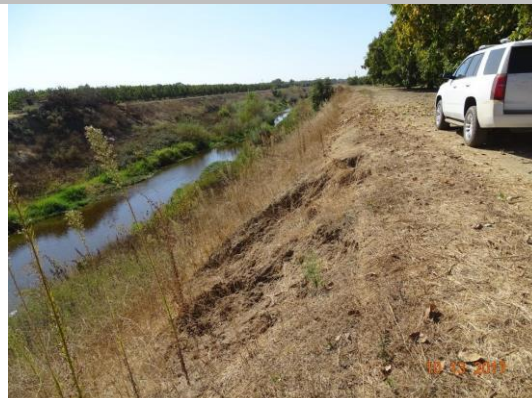
Photo 3 of 3 : SJR2019_FA_2017_NA0017_159_20171023_00437.jpg

Fall 2017: View of slope instability on the waterside slope of the levee looking downstream.

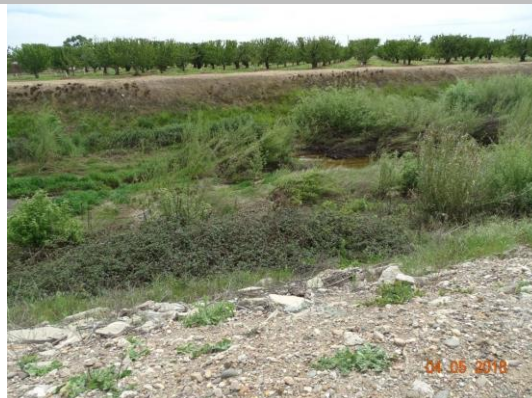
Photo 1 of 1 : FA_2020_NA0017_159_187_20200901_00052.jpg

LM Start	7.96	Rating **	M	Issue No.	187
LM End	7.96	Issue Type +	Ma	Location *	WS
Category	Rivers, Channels & Designated Floodways			GPS Latitude/Longitude	
				Start	End
Item	Vegetation & Obstructions			37.973714 °	37.973714 °
				-121.110653 °	-121.110653 °
DWR ID	DWR_NA0017_15_s_2018_187				
Comment Code					
Inspector Comment					
Vegetation in the channel could reduce flow capacity.

Vegetation in channel looking east.

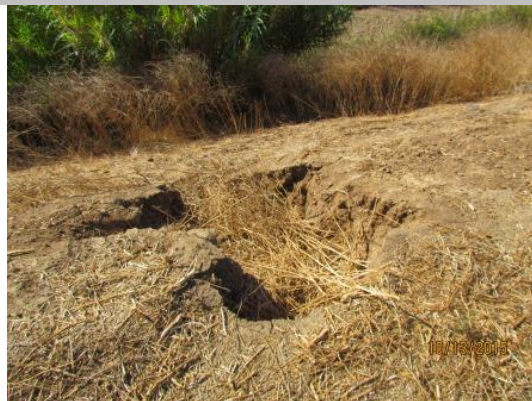
Photo 1 of 1 : FA_2020_NA0017_159_146_20200901_00034.jpg

LM Start	8.39	Rating **	A/W	Issue No.	146
LM End	8.39	Issue Type +	Ma	Location *	WS
Category	Earthen Levee			GPS Latitude/Longitude	
				Start	End
Item	Erosion / Bank Caving			37.969822 °	37.969822 °
				-121.116057 °	-121.116057 °
DWR ID	DWR_NA0017_15_s_2020_146				
Comment Code					
E1 : Note and monitor erosion site.					
Inspector Comment					
This portion of the levee is non-project. Therefore, the rating was given as A/W.

Erosion was found on the waterside of the levee looking downstream.

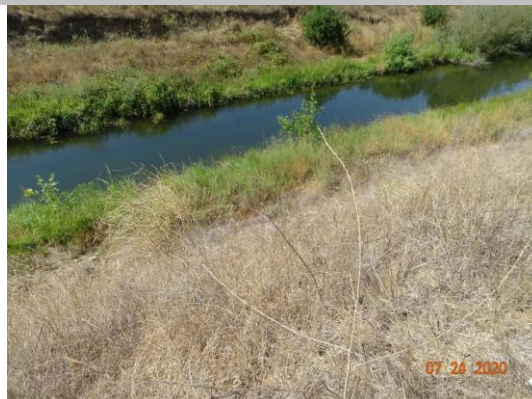
Photo 1 of 2 : SJR2019_NA0017U15RM14.49_01.JPG

LM Start	8.43	Rating **	A/W	Issue No.	4
LM End	8.43	Issue Type +	Ma	Location *	WS
Category	Supplemental			GPS Latitude/Longitude	
				Start	End
Item	DWR Erosion Survey			37.969711 °	37.969711 °
				-121.116739 °	-121.116739 °
DWR ID	NA0017U15RM14.49				
Comment Code					
Inspector Comment					
Site ID: NA0017U15RM14.49					
*This area is patrol road only and therefore the site is not rated					
7/24:2020: From 2014 to present, no significant changes were					
observed during the annual survey. There are signs of animal activity.					
09/12/2013: The erosion has been caused by runoff.

7/24/2020: View of the erosion from the crown.

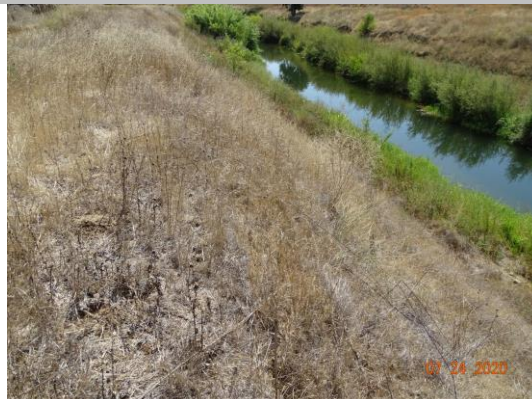
Photo 2 of 2 : SJR2019_NA0017U15RM14.49_02.JPG

7/24/2020: Looking upstream. Erosion is covered by dense vegetation.

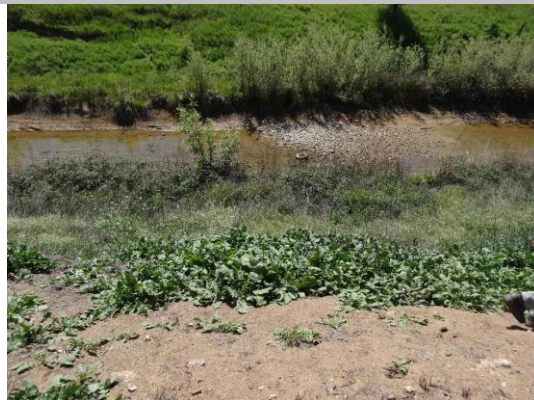
Photo 1 of 3 : UCIP_FA_2020_40386_63765.jpg

LM Start	8.46	Rating **	M	Issue No.	1175	
LM End	8.46	Issue Type +	Ma	Location *		
Category	Supplemental			GPS Latitude/Longitude		
				Start	End	
Item	DWR UCIP LMA Responsibility			37.969690 °	37.969690 °	
				-121.117404 °	-121.117404 °	
DWR ID	23227					
Comment Code						
Inspector Comment						
DS_ID:23227						
FS_ID:40386						
EP_NO: N/A						
Repair Type: Non-Urgent						
EVAL Issue:						
Crossing Status: Found						
UCIP Comments: Distorted inlet pipe opening on landside. No pipe found on waterside. Dense vegetation and steep slope on waterside.						
FIELD_STRUCT_DESC: 18-inch CM pipe through the levee, 1.0 feet below the crown. O&M Manual SJR Assumed 999.						
FS Date: 4/10/2014

WS view: no pipe or appurtenances found on waterside. Dense vegetation.

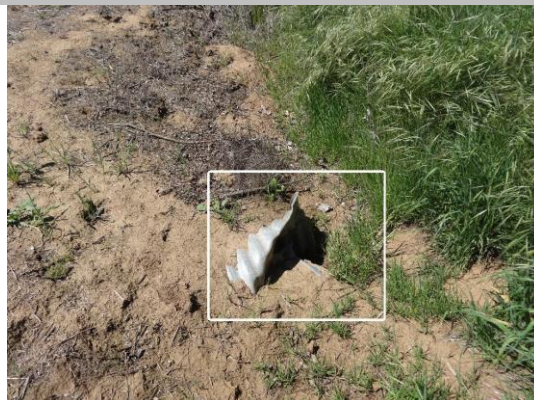
Photo 2 of 3 : UCIP_FA_2020_40386_63764.jpg

LS view: distorted CM outlet pipe on levee slope.

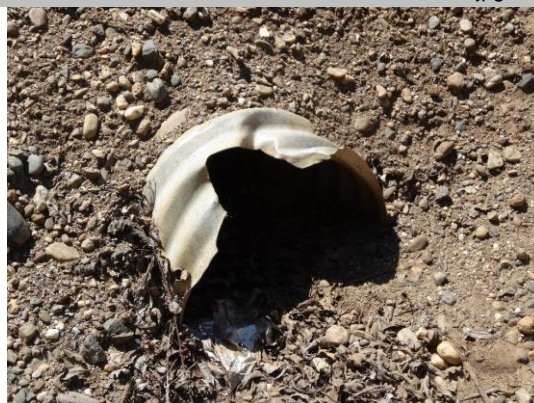
Photo 2 of 2 : UCIP_FA_2020_40387_62948.jpg

LS view: distorted CM inlet pipe. Partially buried.

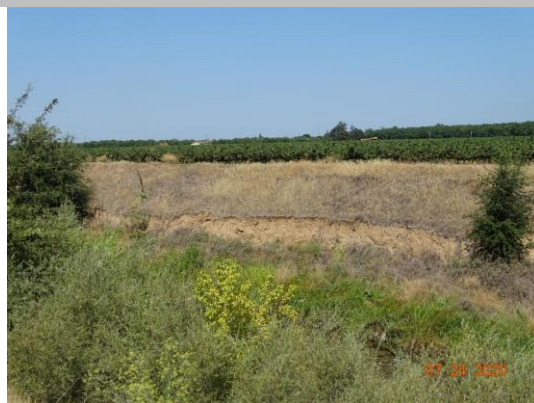
Photo 1 of 2 : SJR2019_NA0017U15RM13.87_02.JPG

*This area is patrol road only and therefore the site is not rated
7/24/2020: From 2015 to present, no significant changes were observed during the annual survey.

7/24/2020: View of the erosion from the opposite bank.

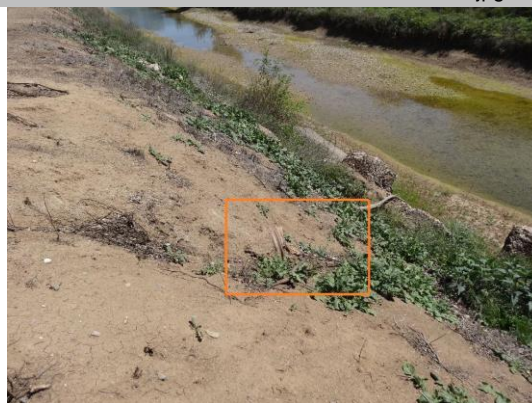
Photo 1 of 3 : UCIP_FA_2020_34983_62966.jpg

LM Start	9.55	Rating **	M	Issue No.	1178	
LM End	9.55	Issue Type +	Ma	Location *		
Category	Supplemental			GPS Latitude/Longitude		
				Start	End	
Item	DWR UCIP LMA Responsibility			37.966327 °	37.966327 °	
				-121.135980 °	-121.135980 °	
DWR ID	23233					
Comment Code						
Inspector Comment						
DS_ID:23233 FS_ID:34983 EP_NO: N/A Repair Type: Non-Urgent EVAL Issue: Crossing Status: Found UCIP Comments: Needs clearing and cleaning of the pipe. FIELD_STRUCT_DESC: 18-inch corrugated metal drainage pipe through the levee, 3.5 feet below the crown. Pipe discharges onto waterside (WS) slope. Slope eroding. [Additional Reference(s): DWR Levee Log, 1992. USACE San Joaquin O&M Manual 611.1, Volume F, (HLM 9.75)]. FS Date: 4/10/2014

WS view: CM outlet pipe on levee slope.

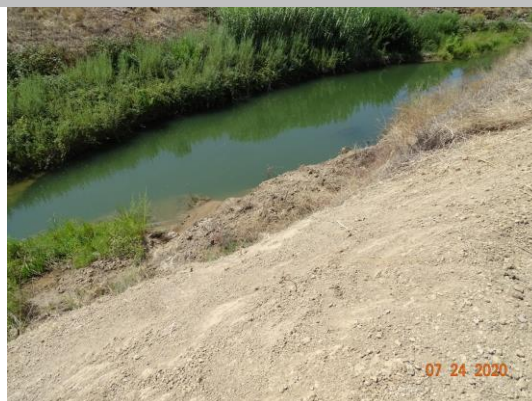
Photo 1 of 2 : SJR2019_NA0017U15RM13.22_01.JPG

LM Start	9.64	Rating **	A/W	Issue No.	17
LM End	9.66	Issue Type +	Ma	Location *	WS
Category	Supplemental			GPS Latitude/Longitude	
				Start	End
Item	DWR Erosion Survey			37.965476 °	37.965476 °
				-121.137512 °	-121.137512 °
DWR ID	NA0017U15RM13.22				
Comment Code					
Inspector Comment					
Site ID: NA0017U15RM13.22					
*This area is patrol road only and therefore the site is not rated					
7/24/2020: The site was discovered during the field survey. The erosion is immediately downstream of a newly repaired erosion site (NA0017U15RM13.25). The erosion begins at the shoulder and extends down the entire slope. Some sloughing is visible on the upper slope and the stream has cut into the bank.

7/24/2020: Looking down the slope at the upstream end of the erosion.

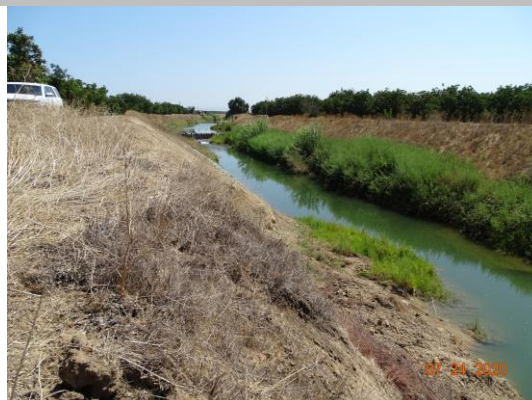
Photo 2 of 2 : SJR2019_NA0017U15RM13.22_05.JPG

7/24/2020: View of the eroded slope looking upstream.

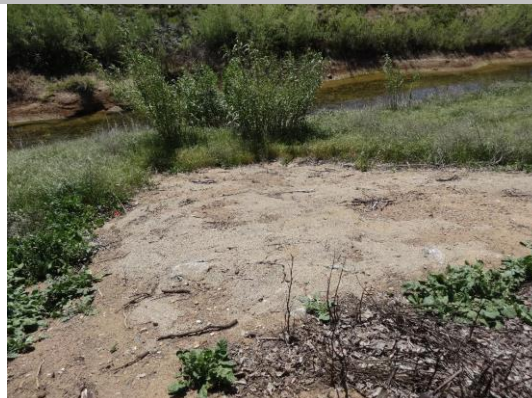
Photo 1 of 3 : UCIP_FA_2020_34986_62986.jpg

LM Start	9.80	Rating **	M	Issue No.	1181	
LM End	9.80	Issue Type +	Ma	Location *		
Category	Supplemental			GPS Latitude/Longitude		
				Start		End
Item	DWR UCIP LMA Responsibility			37.965294 °		37.965294 °
				-121.140184 °		-121.140184 °
DWR ID	23235					
Comment Code						
Inspector Comment						
DS_ID:23235 FS_ID:34986 EP_NO: N/A Repair Type: Non-Urgent EVAL Issue: Crossing Status: Found UCIP Comments: Mud/soil in inlet pipe. Needs cleaning.No pipe or appurtenances visible on waterside. Dense vegetation (may be visible from other channel bank). FIELD_STRUCT_DESC: 18-inch corrugated metal drainage pipe through the levee, 4 feet below the crown. Grouted inlet and outlet. [Additional Reference(s): DWR Levee Log, 1992. USACE San Joaquin O&M Manual 611.1, Volume F, (HLM 10.01)]. FS Date: 4/10/2014

WS view: no pipe or appurtenances found.

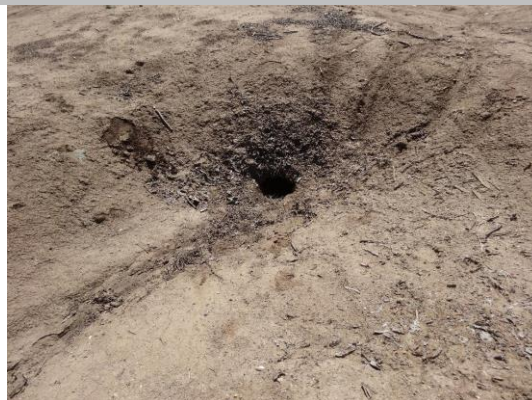
Photo 2 of 3 : UCIP_FA_2020_34986_62985.jpg

LS view: partially buried inlet pipe.

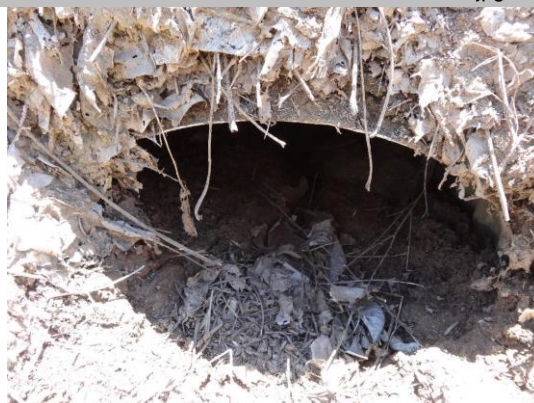
Photo 3 of 3 : UCIP_FA_2020_34986_62984.jpg

LS view: closer view of partially buried inlet pipe. Needs cleaning and clearing.

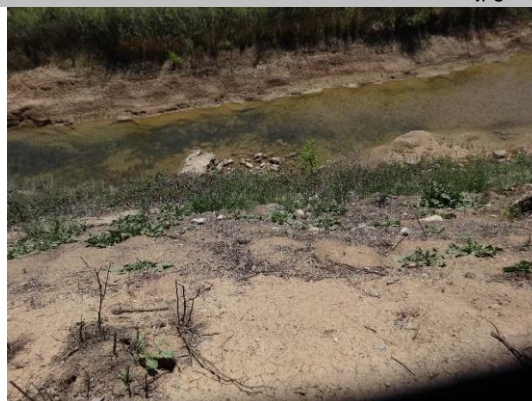
Photo 1 of 3 : UCIP_FA_2020_34987_62992.jpg

LM Start	10.01	Rating **	M	Issue No.	1182
LM End	10.01	Issue Type +	Ma	Location *	
Category	Supplemental			GPS Latitude/Longitude	
				Start	End
Item	DWR UCIP LMA Responsibility			37.965085 °	37.965085 °
				-121.143999 °	-121.143999 °
DWR ID	23236				
Comment Code					
Inspector Comment					
DS_ID:23236 FS_ID:34987 EP_NO: N/A Repair Type: Non-Urgent EVAL Issue: Crossing Status: Found UCIP Comments: May need cleaning of the pipe.Pipe not visible on waterside. FIELD_STRUCT_DESC: 18-inch corrugated metal drainage pipe through the levee, 4.5 feet below the crown. Grouted inlet and outlet. [Additional Reference(s): DWR Levee Log, 1992. USACE San Joaquin O&M Manual 611.1, Volume F, (HLM 10.22)]. FS Date: 4/10/2014

WS view: no pipe or appurtenances found.

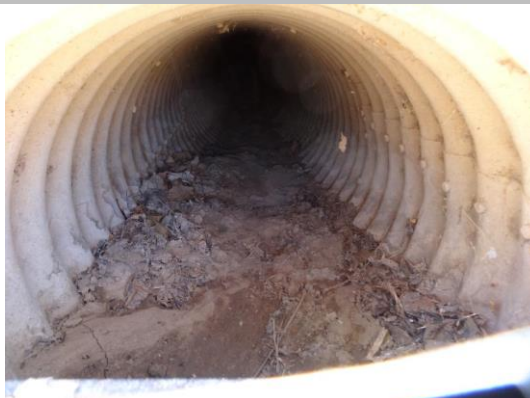
Photo 3 of 3 : UCIP_FA_2020_34987_62991.jpg

LS view: inside view of partially buried inlet pipe. Needs cleaning.

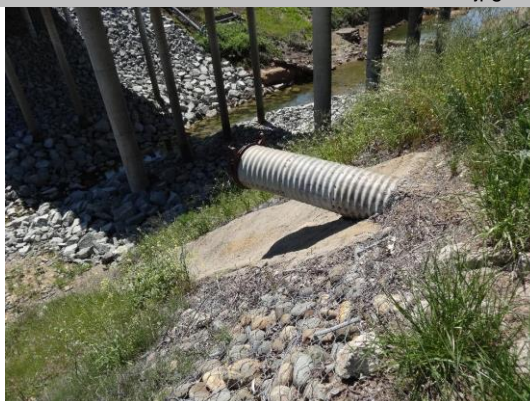
Photo 1 of 2 : UCIP_FA_2020_35003_63003.jpg

DS_ID:23237
 FS_ID:35003
 EP_NO: N/A
 Repair Type: No Action Needed
 EVAL Issue:
 Crossing Status: Found
 UCIP Comments: May need cleaning of the inlet pipe. Vegetation debris on inlet box.
 FIELD_STRUCT_DESC: 18-inch corrugated metal drainage pipe through the levee, 7.5 feet below the crown. Concrete U-shaped headwall on the landside (LS). Flap gate on the waterside (WS).
 [Additional Reference(s): DWR Levee Log, 1992. USACE San Joaquin O&M Manual 611.1, Volume F, (HLM 10.47)].
 FS Date: 4/10/2014

WS view: CM outfall pipe with flapgate on levee slope.

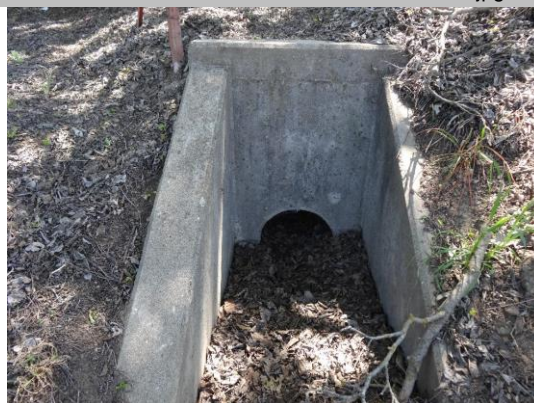
Photo 2 of 2 : UCIP_FA_2020_35003_63002.jpg

LS view: concrete headwall and inlet pipe. Needs cleaning of debris.

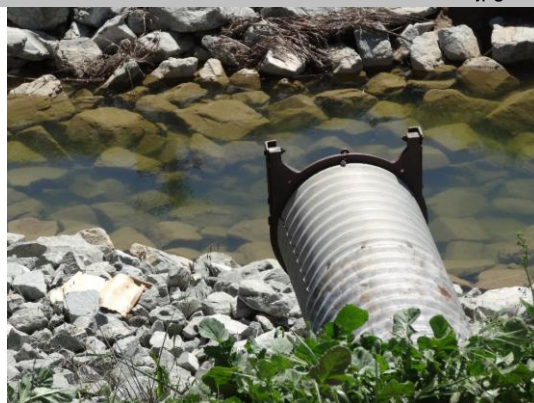
Photo 1 of 2 : UCIP_FA_2020_35005_63011.jpg

DS_ID:23238
 FS_ID:35005
 EP_NO: N/A
 Repair Type: Non-Urgent
 EVAL Issue:
 Crossing Status: Found
 UCIP Comments: Pipe buried on landside. May need cleaning of vegetation debris in inlet opening.
 FIELD_STRUCT_DESC: 18-inch corrugated metal drainage pipe through the levee, 7.5 feet below the crown. Flap gate on the waterside (WS). [Additional Reference(s): DWR Levee Log, 1992. USACE San Joaquin O&M Manual 611.1, Volume F, (HLM 10.49)].
 FS Date: 4/10/2014

WS view: CM outfall pipe with flapgate on levee slope.

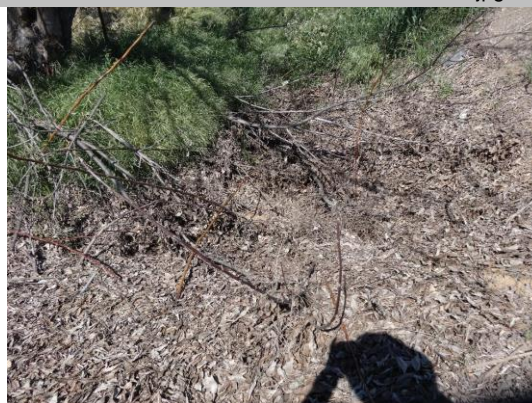
Photo 2 of 2 : UCIP_FA_2020_35005_63010.jpg

LS view: vegetation debris in inlet area. Needs cleaning and clearing.

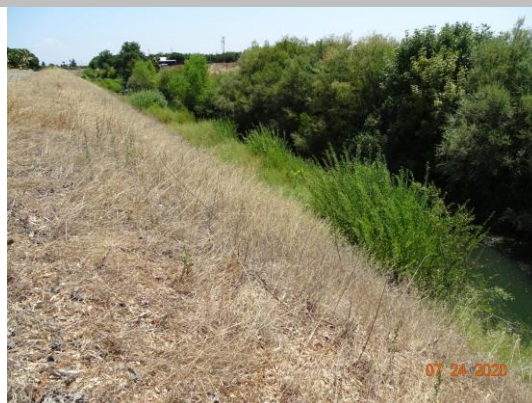
Photo 1 of 2 : SJR2019_NA0017U15RM12.12_01.JPG

7/24/2020: No changes observed since previous inspection.

08/28/2019: The erosion is located at the lower slope of the channel bank and covered by dense vegetation.

7/24/2020: View of the slope looking upstream. The erosion is covered by dense vegetation.

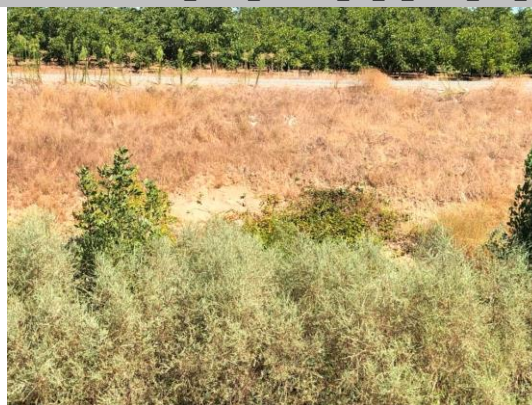
Photo 2 of 2 : SJR2019_DWR_NA0017_15_s_2018_143_4.JPG

8/28/2019: View of the erosion from the opposite bank.

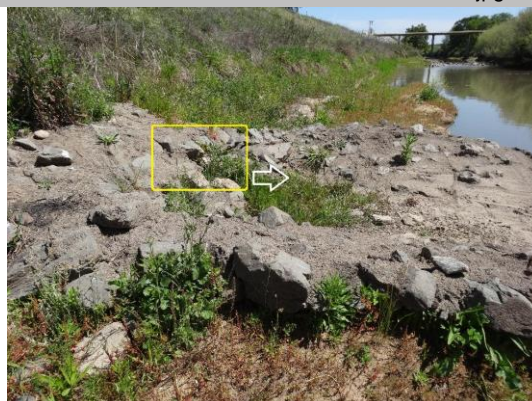
Photo 1 of 2 : UCIP_FA_2020_35010_63035.jpg

WS view: outlet pipe on grouted riprap on levee slope.

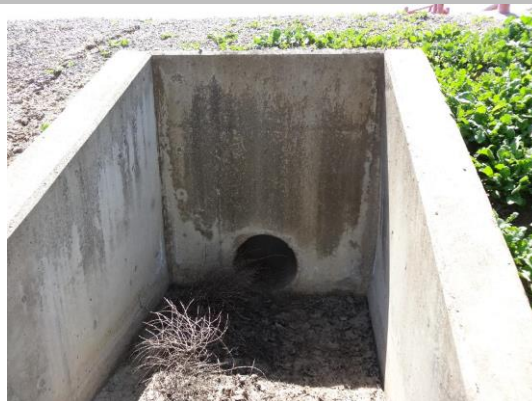
Photo 2 of 2 : UCIP_FA_2020_35010_63034.jpg

LS view: headwall and inlet pipe on levee toe.

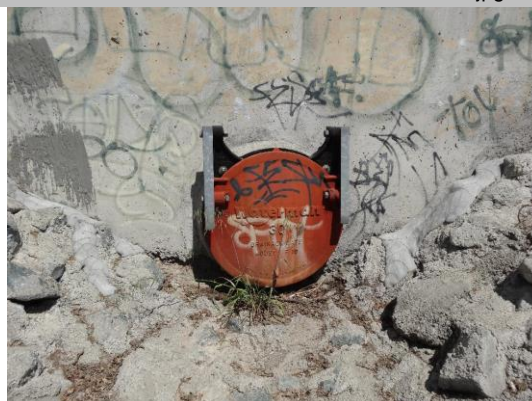
Photo 1 of 2 : UCIP_FA_2020_48304_63039.jpg

WS view: outlet CM pipe with flapgate. Flood wall acts as headwall.

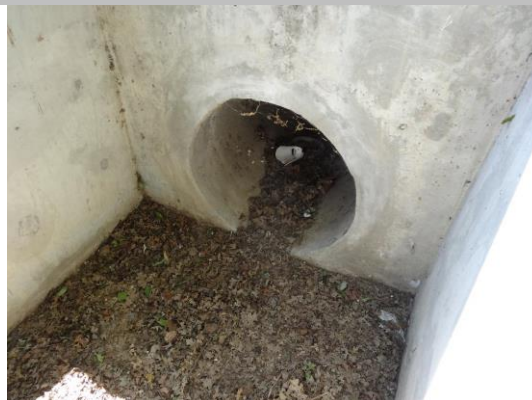
Photo 2 of 2 : UCIP_FA_2020_48304_63038.jpg

LS view: inlet pipe and headwall on levee toe. May need cleaning of inlet opening.

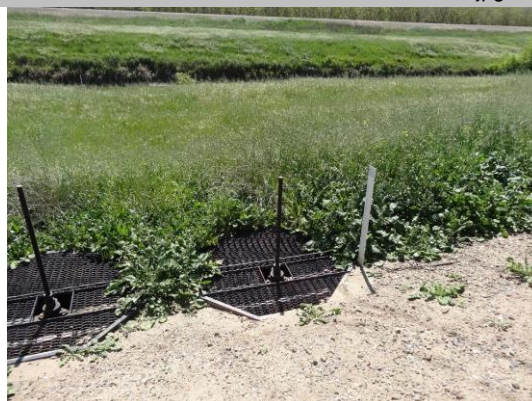
Photo 1 of 3 : UCIP_FA_2020_35014_63053.jpg

WS view: slide gates in CMP risers on levee slope.

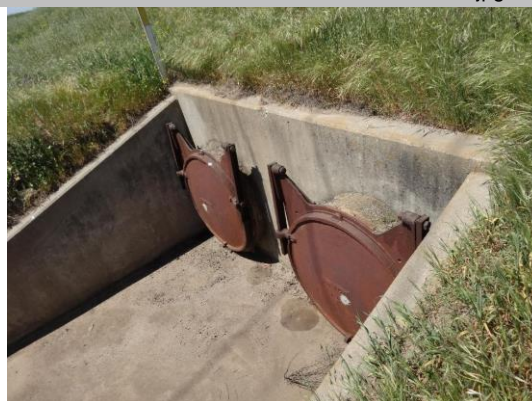
Photo 2 of 3 : UCIP_FA_2020_35015_63058.jpg

WS view: headwall and flap gates on CMP ends on levee slope.

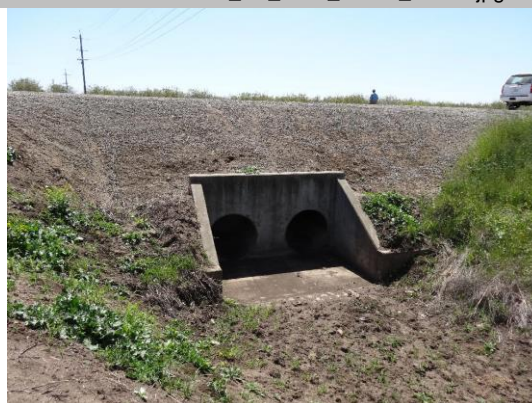
Photo 3 of 3 : UCIP_FA_2020_35015_63057.jpg

LS view: headwall and inlet pipes on levee slope.

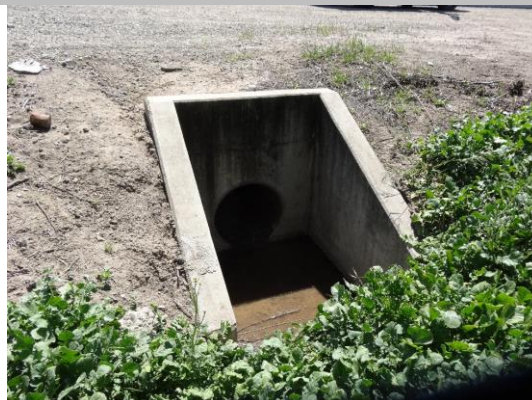
Photo 2 of 3 : UCIP_FA_2020_35043_63084.jpg

LS view: U type concrete headwall and CM inlet Pipe on levee slope. Soil/mud on inlet box.

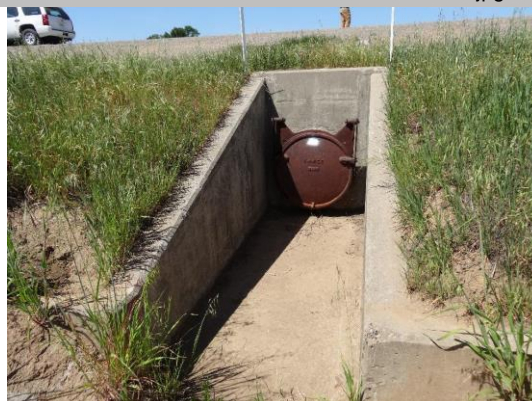
Photo 1 of 3 : UCIP_FA_2020_35047_63100.jpg

WS view: U type concrete headwall, CM pipe with flapgate, and concrete spillway on levee slope.

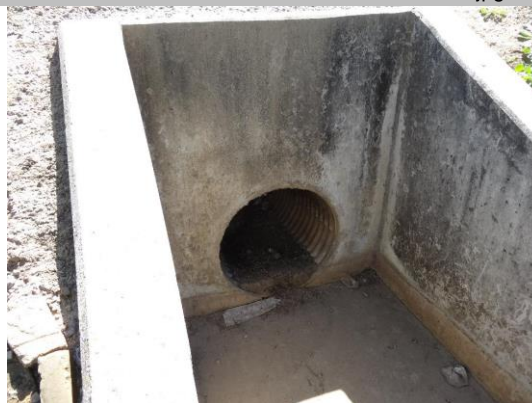
Photo 2 of 3 : UCIP_FA_2020_35047_63099.jpg

LS view: U type concrete headwall and CM inlet Pipe on levee slope.
Soil/mud on inlet box.

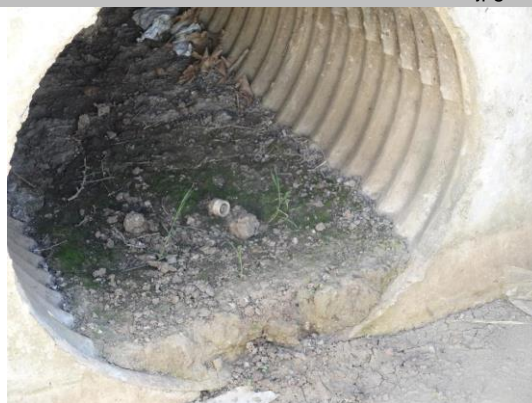
Photo 3 of 3 : UCIP_FA_2020_35047_63101.jpg

LS view: inside view of the CM pipe. Needs cleaning and clearing the pipe.

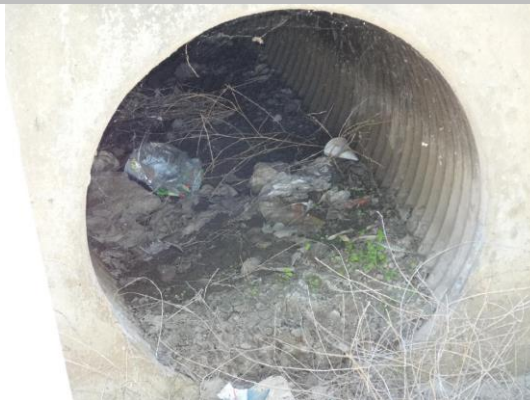
Photo 3 of 3 : UCIP_FA_2020_35049_63111.jpg

LS view: inside view of the CM pipe. Needs cleaning and clearing the pipe.

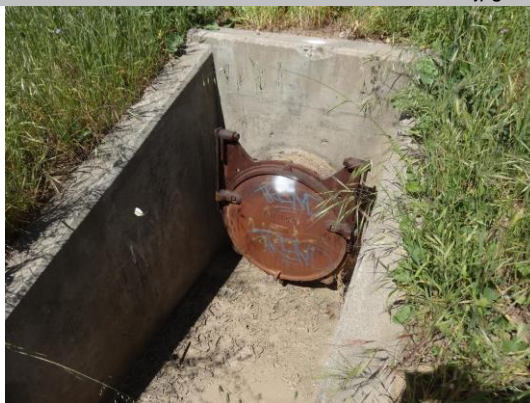
Photo 1 of 3 : UCIP_FA_2020_35064_63131.jpg

DS_ID:23257
 FS_ID:35064
 EP_NO: N/A
 Repair Type: No Action Needed
 EVAL Issue:
 Crossing Status: Found
 UCIP Comments: May need cleaning.
 FIELD_STRUCT_DESC: 30-inch corrugated metal drainage pipe through the levee, 9.5 feet below the crown. Concrete U-shaped headwalls on both ends. Grouted spillway and intake. Flap gate on the waterside (WS). [Additional Reference(s): DWR Levee Log, 1992. USACE San Joaquin O&M Manual 611.1, Volume F, (HLM 13.79)].
 FS Date: 4/14/2014

WS view: U type concrete headwall, CM pipe with flapgate, and concrete spillway on levee slope.

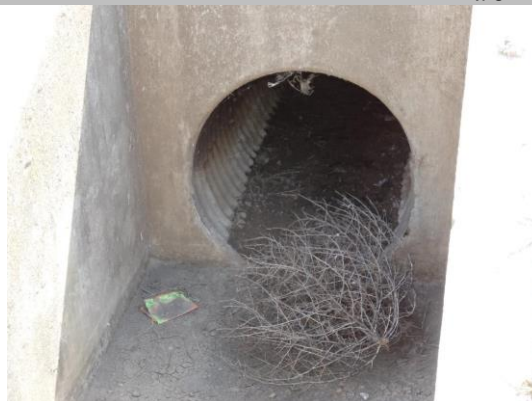
Photo 3 of 3 : UCIP_FA_2020_35064_63129.jpg

LS view: U type concrete headwall and CM inlet Pipe on levee slope. Soil/mud on inlet box.

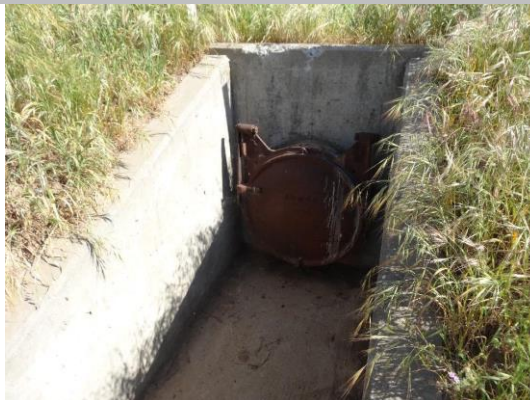
Photo 1 of 3 : UCIP_FA_2020_35104_63192.jpg

WS view: U type concrete headwall, CM pipe with flapgate, and concrete spillway on levee slope.

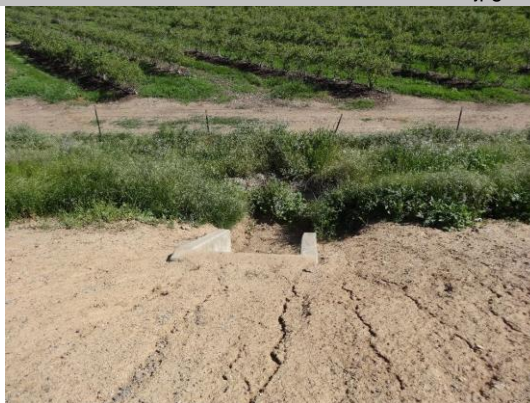
Photo 2 of 3 : UCIP_FA_2020_35104_63191.jpg

LS view: U type concrete headwall on levee slope.

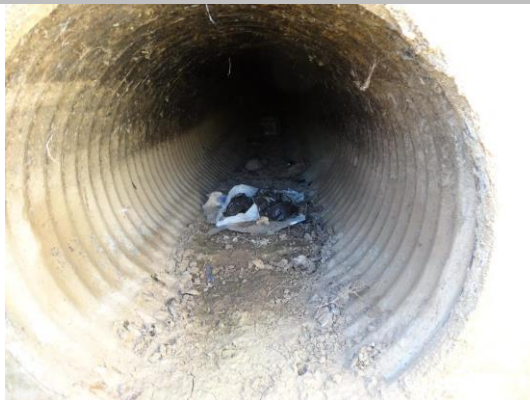
Photo 3 of 3 : UCIP_FA_2020_35104_63193.jpg

LS view: inside view of CM inlet pipe on levee slope. Debris on inlet pipe. Needs cleaning.

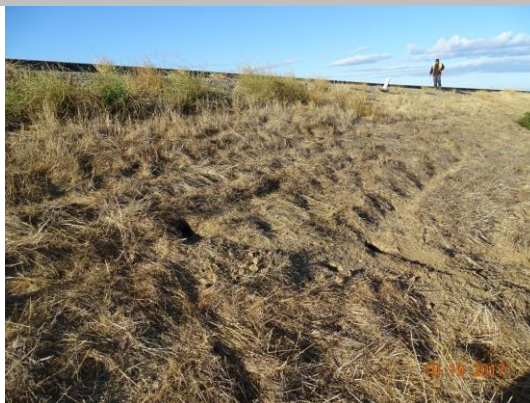
Photo 1 of 1 : FA_2020_NA0017_159_154_20200901_00038.jpg

LM Start	15.37	Rating **	M	Issue No.	154
LM End	15.37	Issue Type +	Ma	Location *	LS
Category	Earthen Levee			GPS Latitude/Longitude	
				Start	End
Item	Animal Control			37.975671 °	37.975671 °
				-121.234277 °	-121.234277 °
DWR ID	DWR_NA0017_15_f_2015_154				
Comment Code					
A3 : No rodents visible, but rodent burrows visible; need to backfill and compact or grout burrows.					
Inspector Comment

View of rodent holes on the landside of the levee. Fall 2017

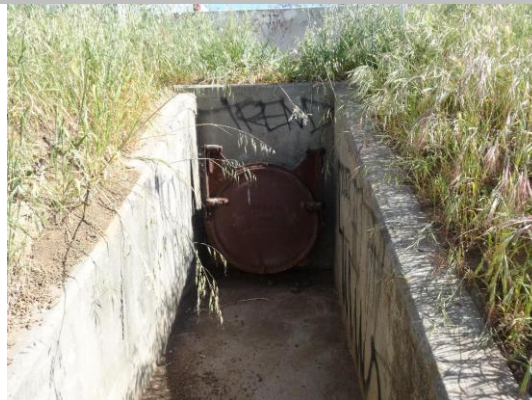
Photo 1 of 2 : UCIP_FA_2020_35105_63197.jpg

WS view: U type concrete headwall, CM pipe with flapgate, and concrete spillway on levee slope.

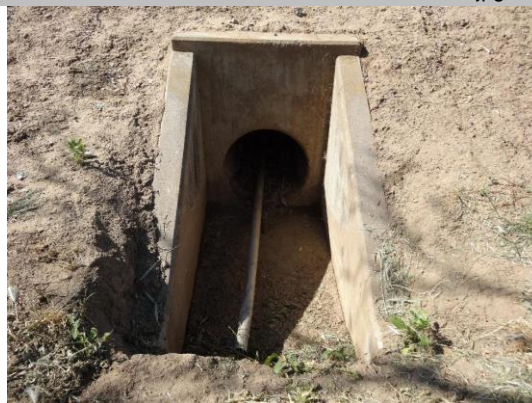
Photo 2 of 2 : UCIP_FA_2020_35105_63196.jpg

LS view: U type concrete headwall and CM pipe on levee slope. Debris in inlet pipe.

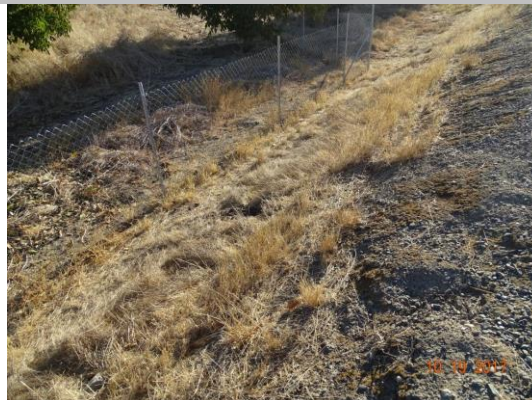
Photo 1 of 1 : FA_2020_NA0017_159_194_20200901_00054.jpg

LM Start	15.40	Rating **	M	Issue No.	194
LM End	15.43	Issue Type +	Ma	Location *	LS
Category	Earthen Levee			GPS Latitude/Longitude	
				Start	End
Item	Animal Control			37.975839 °	37.976042 °
				-121.234763 °	-121.235213 °
DWR ID	DWR_NA0017_15_f_2020_194				
Comment Code					
A3 : No rodents visible, but rodent burrows visible; need to backfill and compact or grout burrows.					
Inspector Comment

Picture of the rodent holes on the landside shoulder of the levee. Fall 2017

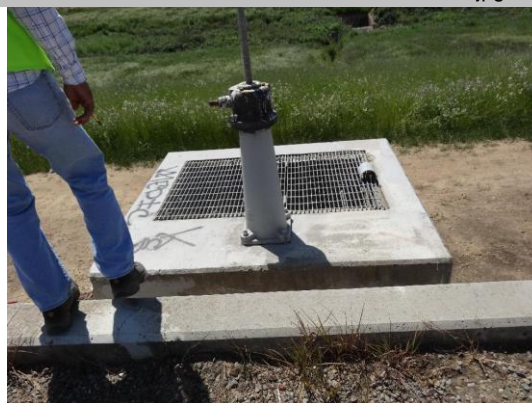
Photo 1 of 3 : UCIP_FA_2020_35163_63285.jpg

WS view: slide gate in a concrete box on levee shoulder.

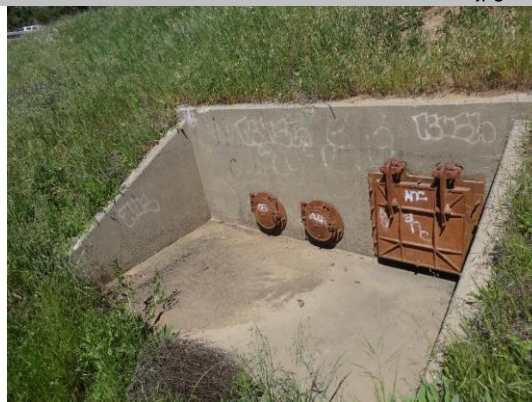
Photo 2 of 3 : UCIP_FA_2020_35163_63284.jpg

WS view: U type concrete headwall, 14" CM pipes and 30" RC culvert with flapgate, and concrete spillway on levee slope.

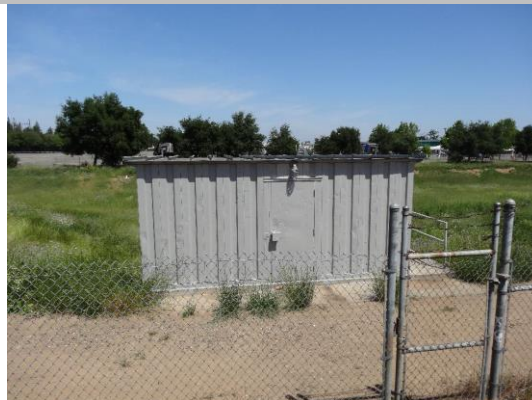
Photo 3 of 3 : UCIP_FA_2020_35163_63283.jpg

LS view: pump house inside wired fence on levee slope.

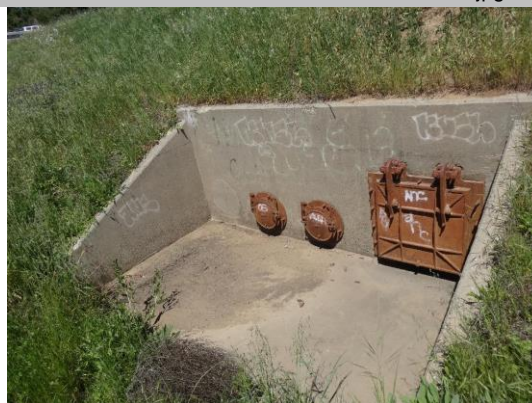
Photo 1 of 2 : UCIP_FA_2020_35164_63289.jpg

WS view: U type concrete headwall, 14" CM pipes and 30" RC culvert with flapgate, and concrete spillway on levee slope.

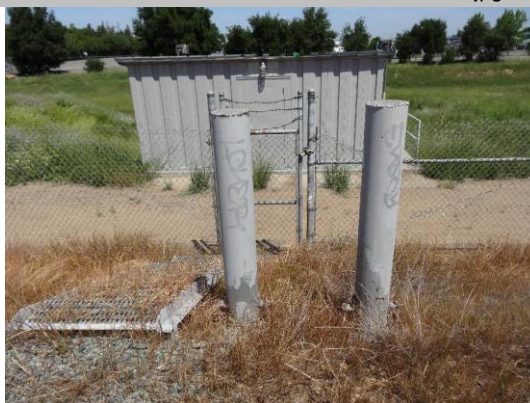
Photo 2 of 2 : UCIP_FA_2020_35164_63288.jpg

LS view: siphon breakers in steel pipe risers and pump house on levee slope.

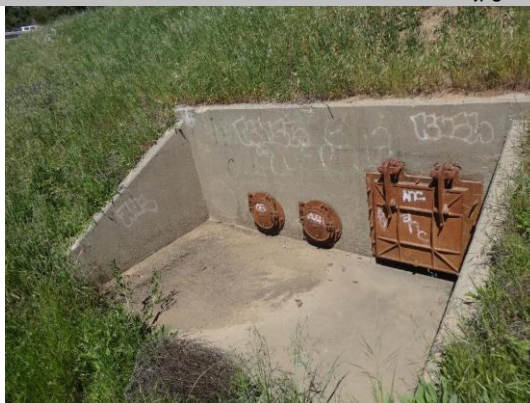
Photo 1 of 2 : UCIP_FA_2020_35165_63293.jpg

WS view: U type concrete headwall, 14" CM pipes and 30" RC culvert with flapgate, and concrete spillway on levee slope.

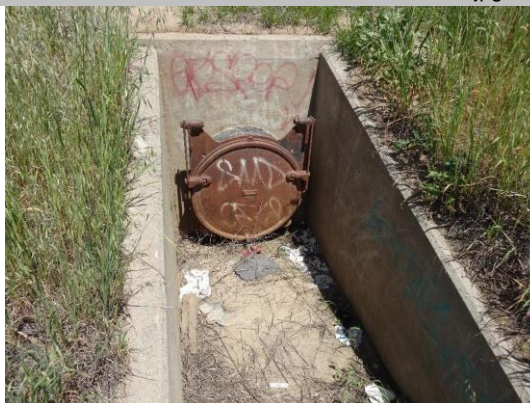
Photo 1 of 3 : UCIP_FA_2020_35183_63325.jpg

WS view: U type concrete headwall, CM pipe with flapgate, and concrete spillway on levee slope.

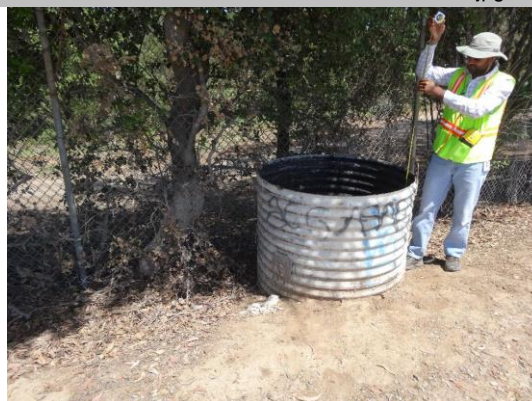
Photo 2 of 3 : UCIP_FA_2020_35183_63324.jpg

DS_ID:23267
 FS_ID:35183
 EP_NO: N/A
 Repair Type: Non-Urgent
 EVAL Issue:
 Crossing Status: Found
 UCIP Comments: CMP riser needs cleaning.
 FIELD_STRUCT_DESC: 30-inch corrugated metal drainage pipe through the levee, 13 feet below the crown. Concrete U-shaped headwall on the waterside (WS). Corrugated metal riser unit at the landside (LS) toe. [Additional Reference(s): DWR Levee Log, 1992. USACE San Joaquin O&M Manual 611.1, Volume F, (HLM 18.01)].
 FS Date: 4/15/2014

LS view: CMP riser on levee shoulder.
