**Flood Control Project Maintenance
Levee Inspections**

Maintenance Issue Types Only, Levee Inspection Report By Mile - Fall 2020

San Joaquin County Flood Control and Water Conservation District

Waterway	Bank	Unit Miles	Inspection Start/End	Inspector
Unit No. 01 Littlejohn Creek	Left	2.59	10/20/2020 10/20/2020	Alberto De Leon

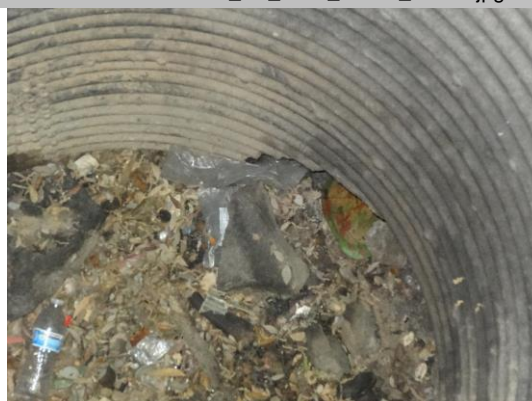
Photo 3 of 3 : UCIP_FA_2020_35183_63323.jpg

LS view: inside view of CMP riser on levee shoulder. It needs cleaning and clearing.

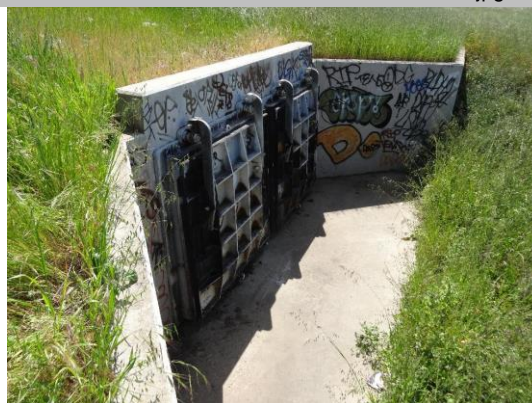
Photo 1 of 3 : UCIP_FA_2020_35463_63782.jpg

WS view: outlet structure with two flapgates and concrete spillway on levee toe.

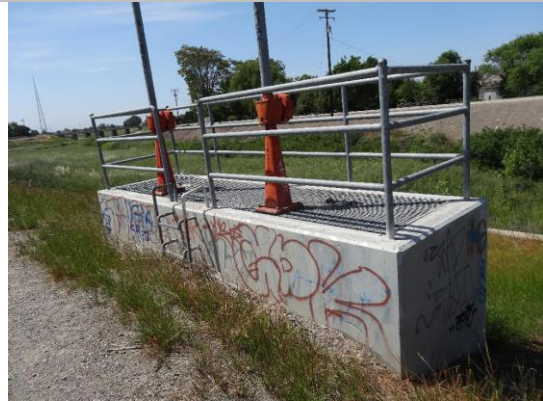
Photo 2 of 3 : UCIP_FA_2020_35463_63781.jpg

WS view: two slide gates in concrete box on levee shoulder.

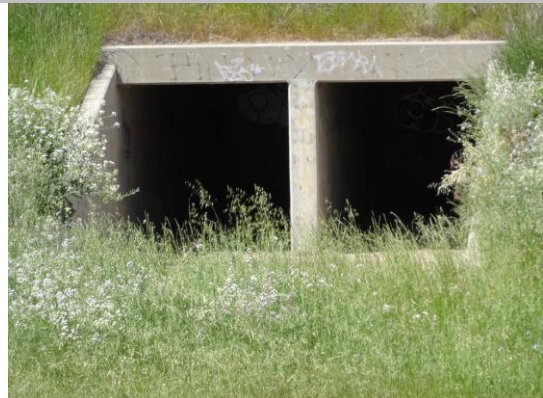
Photo 3 of 3 : UCIP_FA_2020_35463_63780.jpg

LS view: double 6 ft by 6 ft concrete box culvert through the levee.

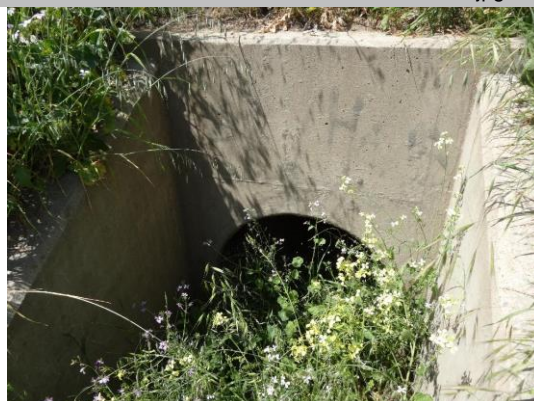
Photo 1 of 3 : UCIP_FA_2020_35203_63345.jpg

LS view: U type concrete headwall and CM pipe on levee slope.

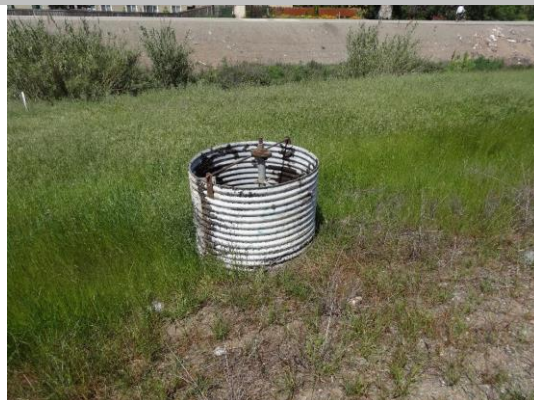
Photo 2 of 3 : UCIP_FA_2020_35203_63344.jpg

WS view: slide gate in CMP riser on levee slope. Slide gate handle missing.

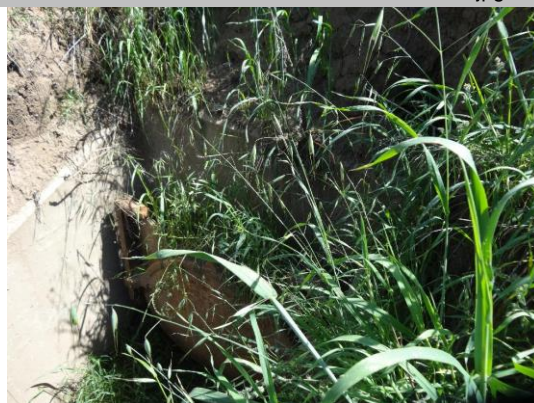
Photo 3 of 3 : UCIP_FA_2020_35203_63343.jpg

WS view: U type concrete headwall, CM pipe with flapgate, and concrete spillway on levee slope.

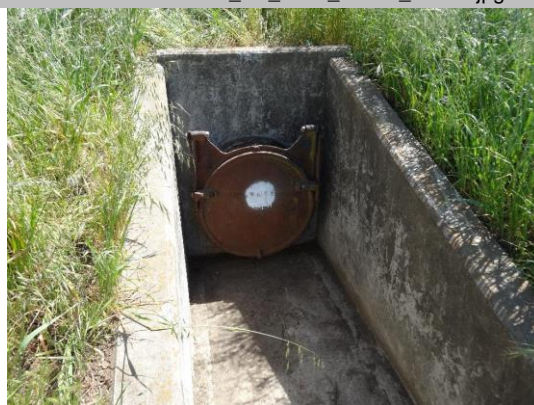
Photo 1 of 2 : UCIP_FA_2020_35204_63349.jpg

WS view: U type concrete headwall, CM pipe with flapgate, and concrete spillway on levee slope.

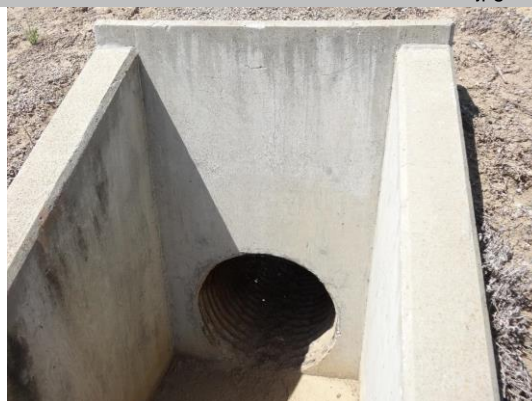
Photo 2 of 2 : UCIP_FA_2020_35204_63348.jpg

LS view: U type concrete headwall and CM pipe on levee slope.

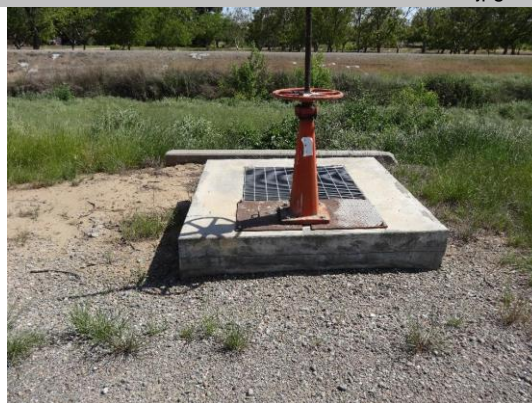
Photo 1 of 3 : UCIP_FA_2020_35206_63361.jpg

WS view: slide gate in a concrete box on levee shoulder.

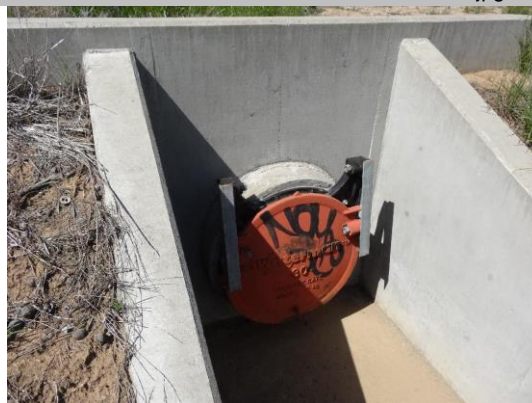
Photo 2 of 3 : UCIP_FA_2020_35206_63360.jpg

WS view: U type concrete headwall, CM pipe with flapgate, and concrete spillway on levee slope.

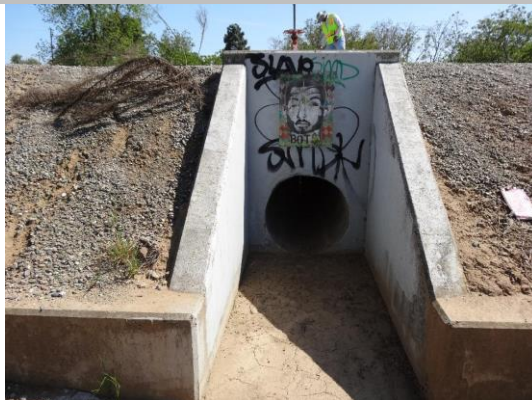
Photo 3 of 3 : UCIP_FA_2020_35206_63359.jpg

LS view: U type concrete headwall and CM pipe on levee slope.

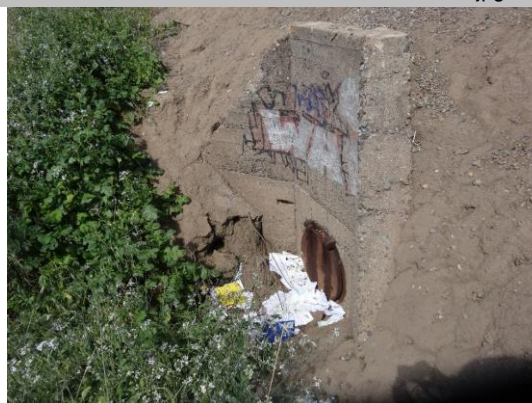
Photo 1 of 3 : UCIP_FA_2020_53535_63421.jpg

Comment Code						
Inspector Comment						
DS_ID:23274 FS_ID:53535 EP_NO: N/A Repair Type: Non-Urgent EVAL Issue: Crossing Status: Found UCIP Comments: 11/16/2018 Internal video inspection revealed a concrete plug in the pipe, 49.2 feet from the outlet on the WS. Pipe improperly abandoned. Abandon properly or remove from levee. Crossing escalated to "Non-Urgent" due to the improper abandonment. Material type changed from steel to reinforced concrete. (A. McDonald - DWR UCIP)Concrete headwall not found on the LS. Manhole found on the LS. FIELD_STRUCT_DESC: *ABANDONED* 24-inch reinforced concrete gravity drainage pipe through the levee, 12 feet below the crown. Flap gate and concrete headwall on the waterside (WS). Manhole on the landside (LS). Pipe partially plugged with concrete on the LS. [Additional Reference(s): DWR Levee Log, 1992. USACE San Joaquin O&M Manual 611.1, Volume F, (HLM 20.14)]. FS Date: 11/16/2018

WS view: concrete headwall and steel pipe with flapgate on levee slope.
Vegetation and debris on spillway.

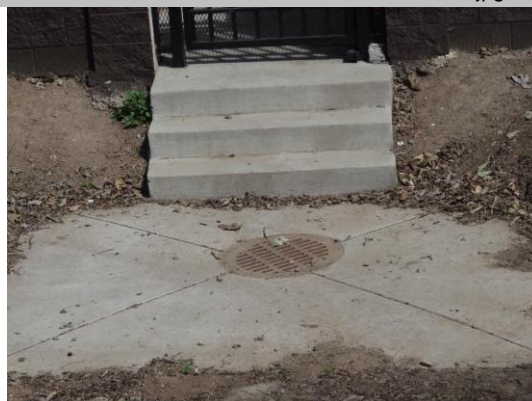
Photo 2 of 3 : UCIP_FA_2020_53535_63420.jpg

LS view: a manhole on levee toe.

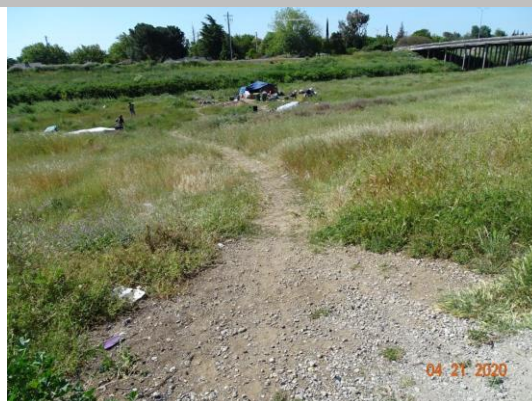
Photo 1 of 1 : FA_2020_NA0017_159_165_20200901_00043.jpg

View of pedestrian path on landside slope. Spring 2020

LM Start	20.92	Rating **	M	Issue No.	165
LM End	20.92	Issue Type +	Ma	Location *	WS
Category	Earthen Levee			GPS Latitude/Longitude	
				Start	End
Item	Slope Stability			37.992012 °	37.992012 °
				-121.302761 °	-121.302761 °
DWR ID	DWR_NA0017_15_s_2020_165				
Comment Code					
S2 : Repair the levee slope damaged by foot traffic and prevent access where possible.					
Inspector Comment

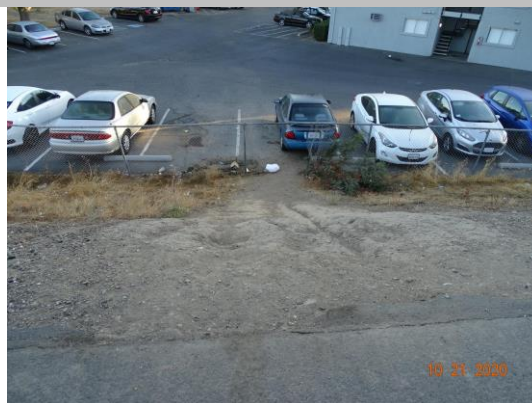
Photo 1 of 1 : FA_2020_NA0017_159_134_20201021_00255.jpg

View of pedestrian path on landside slope. Fall 2020

LM Start	22.26	Rating **	M	Issue No.	134
LM End	22.26	Issue Type +	Ma	Location *	LS
Category	Earthen Levee			GPS Latitude/Longitude	
				Start	End
Item	Slope Stability			37.980937 °	37.980937 °
				-121.319809 °	-121.319809 °
DWR ID	DWR_NA0017_15_s_2020_134				
Comment Code					
S2 : Repair the levee slope damaged by foot traffic and prevent access where possible.					
Inspector Comment

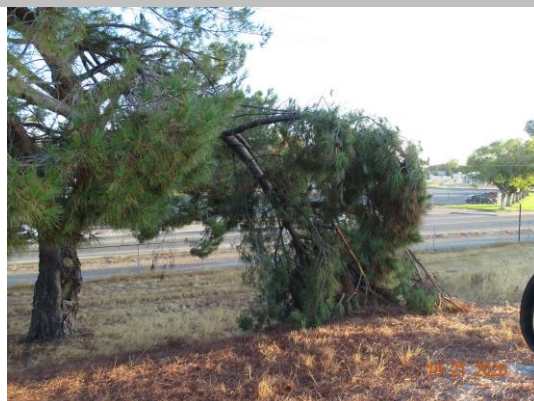
Photo 1 of 1 : FA_2020_NA0017_159_190_20201021_00254.jpg

View of broken off tree branch on landside slope. Fall 2020

LM Start	22.55	Rating **	M	Issue No.	190
LM End	22.55	Issue Type +	Ma	Location *	LS
Category	Earthen Levee			GPS Latitude/Longitude	
				Start	End
Item	Trim / Thin Trees			37.981920 °	37.981920 °
				-121.324943 °	-121.324943 °
DWR ID	DWR_NA0017_15_f_2019_190				
Comment Code					
T3 : Trim and thin trees to allow visibility of the ground and room to flood fight.					
Inspector Comment

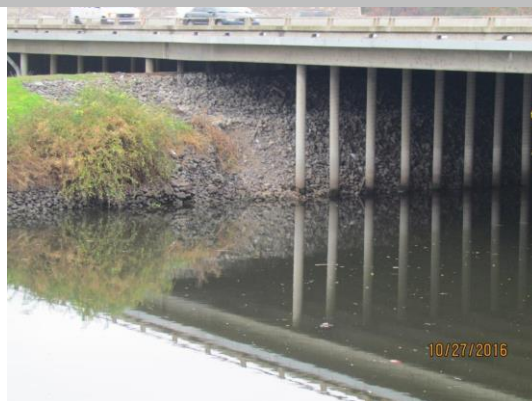
Photo 1 of 1 : FA_2020_NA0017_159_223_20200901_00061.jpg

LM Start	23.55	Rating **	A/W	Issue No.	223
LM End	23.55	Issue Type +	Ma	Location *	WS
Category	Earthen Levee			GPS Latitude/Longitude	
				Start	End
Item	Riprap Revetments			37.979282 °	37.979282 °
				-121.341686 °	-121.341686 °
DWR ID	DWR_NA0017_15_f_2016_223				
Comment Code					
Inspector Comment					
Wrong revetment size was placed by Caltrans in Fall 2012 under permit #18562. An NOV was issued to Caltrans. They repaired the left bank, but have not repaired the right bank of the levee. Caltrans will be responsible for any repairs at this location.

View of deteriorating revetments on the waterside toe of the levee. The picture was taken from the opposite side of the levee. Fall 2016

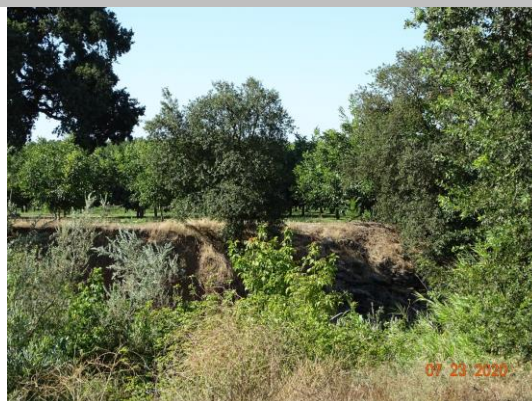
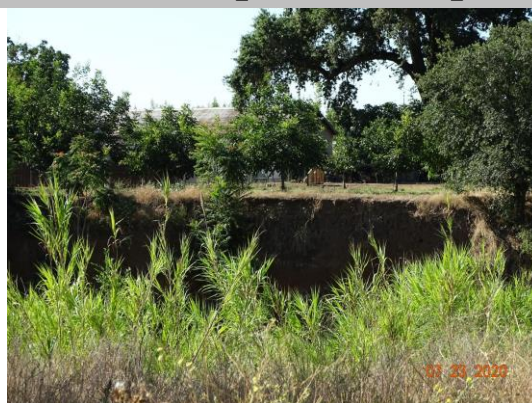
7/23/2020: View of the erosion from the opposite bank.

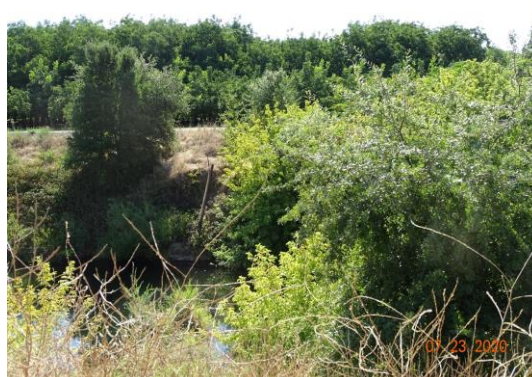
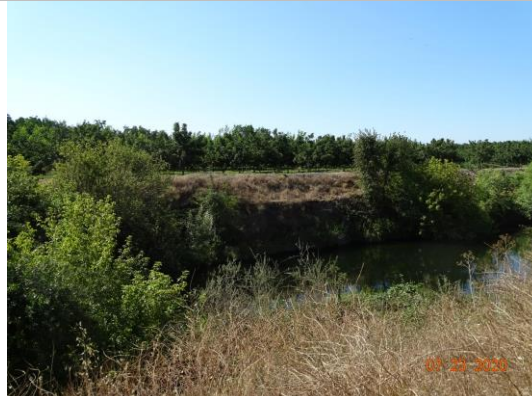
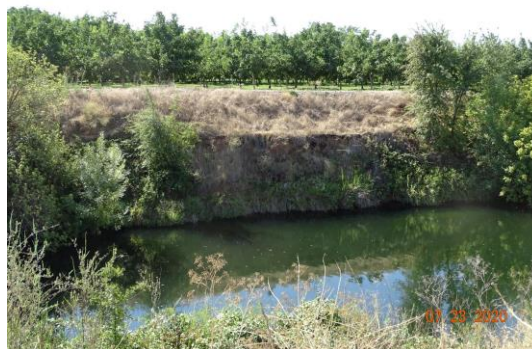
08/22/2012: The erosion was surveyed and documented for monitoring purpose. There is no levee structure on the site, only high ground protecting the land behind. There is a drainage pipe at the site, which might have caused the problem at one pocket erosion.

7/23/2020: View of the erosion from the opposite bank.

7/23/2020: View of the erosion a little further downstream.

7/23/2020: A more close-up view of the erosion from the opposite bank.

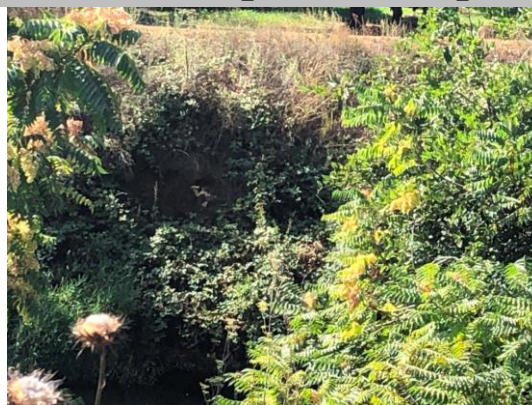
LM Start	1.59	Rating **	A/W	Issue No.	37
LM End	1.59	Issue Type +	Ma	Location *	WS
Category	Supplemental			GPS Latitude/Longitude	
				Start	End
Item	DWR Erosion Survey			38.038751 °	38.038751 °
				-121.037347 °	-121.037347 °
DWR ID	NA0017U16RM22.15				
Comment Code					
Inspector Comment					
Site ID: NA0017U16RM22.15					
*This area is patrol road only and therefore the site is not rated					
7/23/2020: From 2013 to present, no significant changes were					
observed during the annual survey.					
08/22/2012: The berm is estimated at 10 ft. Dense vegetation on site.					
There is no levee structure on site.

7/23/2020: View of the erosion from the opposite bank.

8/28/2019: Close-up view of the erosion.

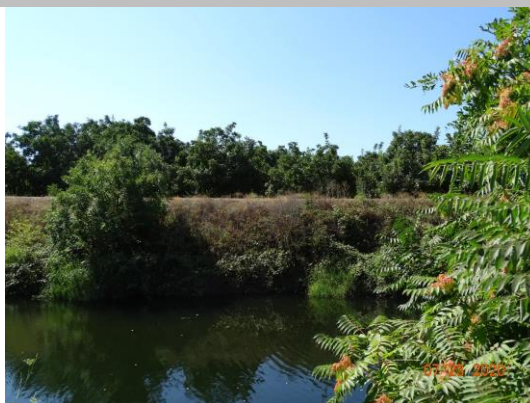
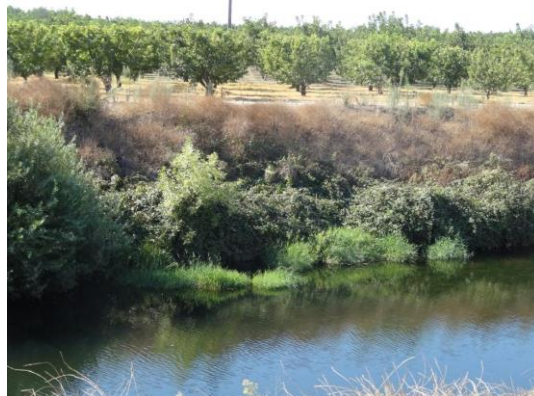
LM Start	1.67	Rating **	A/W	Issue No.	38
LM End	1.68	Issue Type +	Ma	Location *	WS
Category	Supplemental			GPS Latitude/Longitude	
				Start	End
Item	DWR Erosion Survey			38.038671 °	38.038671 °
				-121.037405 °	-121.037405 °
DWR ID	NA0017U16RM22.01				
Comment Code					
Inspector Comment					
Site ID: NA0017U16RM22.01					
*This area is patrol road only and therefore the site is not rated					
7/23/2020: From 2013 to present, no significant changes were observed during the annual survey.					
08/22/2012: Site is covered with dense vegetation. A scarp erosion is adjacent to a pocket erosion at the downstream. There is no levee structure on site.

7/23/2020: View of the erosion from the opposite bank.

8/28/2019: Looking at the erosion from the other side of the channel.

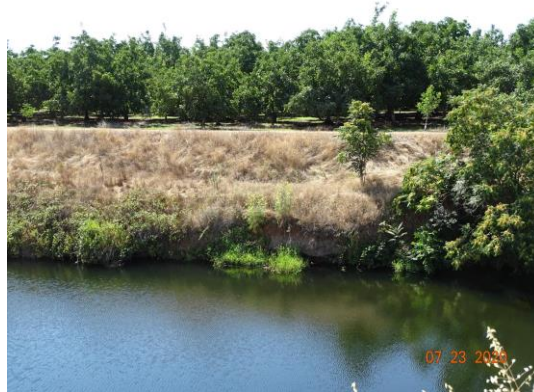
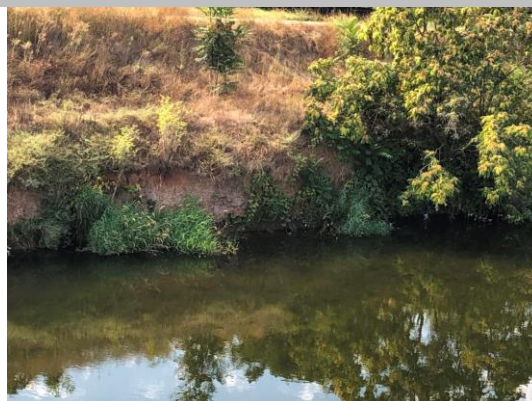
*This area is patrol road only and therefore the site is not rated
7/23/2020: From 2013 to present, no significant changes were observed during the annual survey. The scarp is nearly vertical at the toe.

08/22/2012: The erosion is covered by dense vegetation. There is no levee structure on site.

7/23/2020: View of the erosion from the opposite bank.

8/28/2019: Close-up view of the erosion.

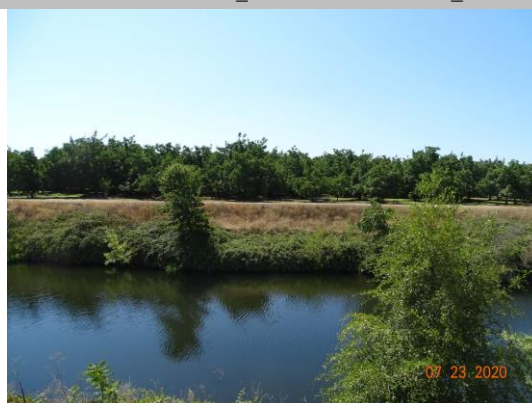
Photo 1 of 2 : SJR2019_NA0017U16RM21.94_01.JPG

7/23/2020: View of the erosion from the opposite bank.

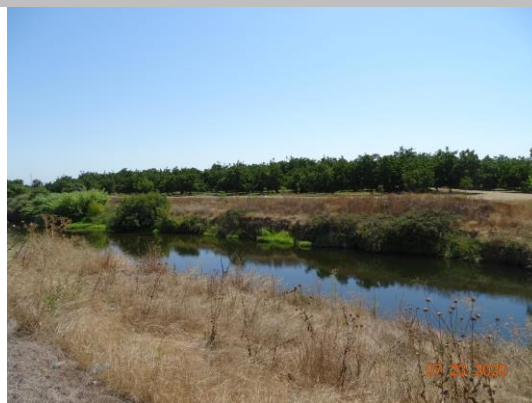
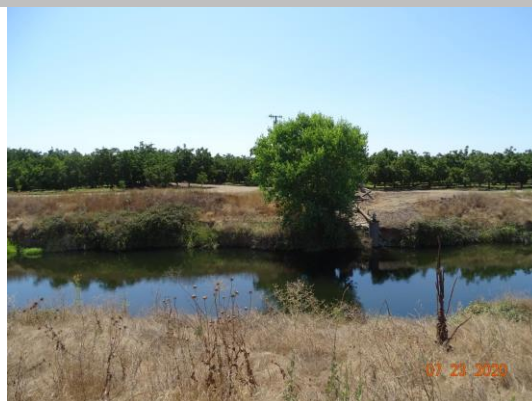
LM Start	1.87	Rating **	A/W	Issue No.	41
LM End	1.91	Issue Type +	Ma	Location *	WS
Category	Supplemental			GPS Latitude/Longitude	
				Start	End
Item	DWR Erosion Survey			38.036549 °	38.036549 °
				-121.040302 °	-121.040302 °
DWR ID	NA0017U16RM21.05				
Comment Code					
Inspector Comment					
Site ID: NA0017U16RM21.05					
*This area is patrol road only and therefore the site is not rated 7/23/2020: From 2013 to present, no significant changes were observed during the annual survey. This site was combined with a site immediately downstream (NA0017U16RM21.03). The erosion is just up and downstream of an irrigation pipe crossing (see DSIDs 23321/24938).					
08/22/2012: Berm width is estimated as 5 ft. There is no levee structure on site.

7/23/2020: View of the erosion from the opposite bank, just upstream of the pipe crossing.

7/23/2020: View of the erosion and pipe crossing.

7/23/2020: Close-up view of the erosion just upstream of the pipe crossing.

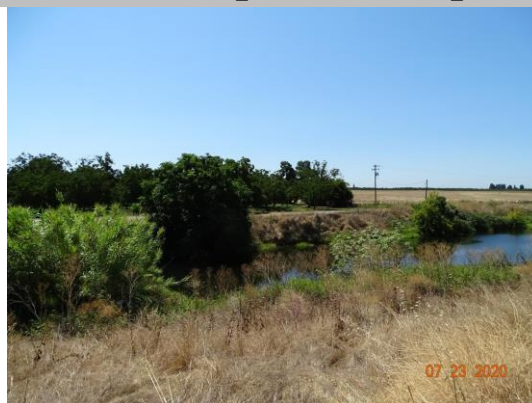
Photo 1 of 2 : SJR2019_NA0017U16RM20.71_01.JPG

08/22/2012: Site is covered with dense vegetation. There is no levee structure on site.

7/23/2020: View of the erosion from the opposite bank.

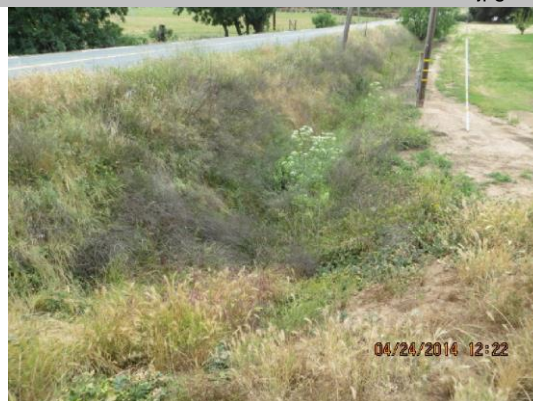
Photo 1 of 3 : UCIP_FA_2020_53506_64067.jpg

Comment Code					
Inspector Comment					
DS_ID:23446 FS_ID:53506 EP_NO: N/A Repair Type: Non-Urgent EVAL Issue: Crossing Status: Found UCIP Comments: 09/18/2018 Lots of sediment in the inlet: needs to be cleared out. No integrity issues, yet there's dense vegetation and potential flooding risk during high water. Crossing downgraded to "Non-Urgent." (A. McDonald - DWR UCIP)10/31/2016 Same as last inspection. Pipe is open on both ends, no flap gate. (O. Magana - DWR UCIP)04/24/2014 Pipe in non-project levee area. Pipe open on both ends, no flapgate. (W. Wylie - DWR UCIP) FIELD_STRUCT_DESC: 36-inch corrugated metal drainage culvert through the levee, 10 feet below the crown. Pipe open on both ends. [Additional Reference(s): USACE San Joaquin O&M Manual Unit 611, Part No. 1 – Mormon Slough Project, Unit 15 Mormon Slough: HLM 1.18 – 13.46, Unit 15 Diverting Canal: HLM 13.79 – 18.01, Unit 15 Calaveras River LB: 18.54-18.76, Unit 15 Calaveras River RB: HLM 19.35 – 25.38, Unit 16 Mormon Slough: 0.27 – 13.18, Unit 16 Diverting Canal: 14.71 – 17.79, Unit 16 Calaveras River: 18.98 – 23.36, Unit 17 Potter Creek RB: 0.33 – 0.60, Unit 18 Potter Creek LB: 0.00-0.55, (HLM 2.82)] FS Date: 9/18/2018

Pipe inlet on LS toe.

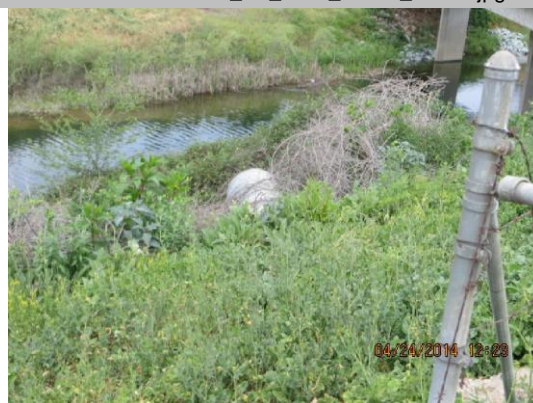
Photo 2 of 3 : UCIP_FA_2020_53506_64066.jpg

Pipe outlet on WS slope.

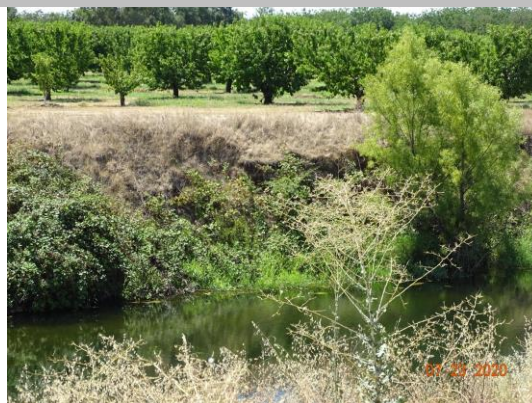
Photo 2 of 3 : SJR2019_NA0017U16RM20_02.JPG

7/23/2020: Close-up view of the erosion.

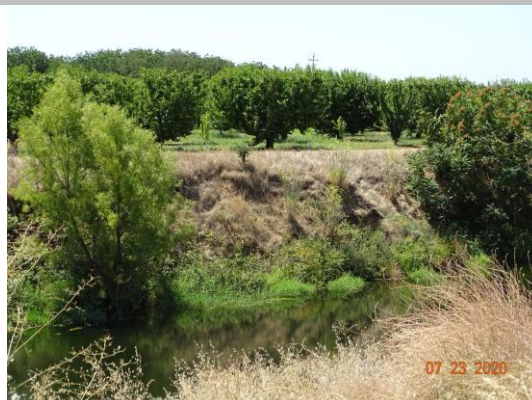
Photo 3 of 3 : SJR2019_NA0017U16RM20_03.JPG

7/23/2020: Another close-up view of the erosion.

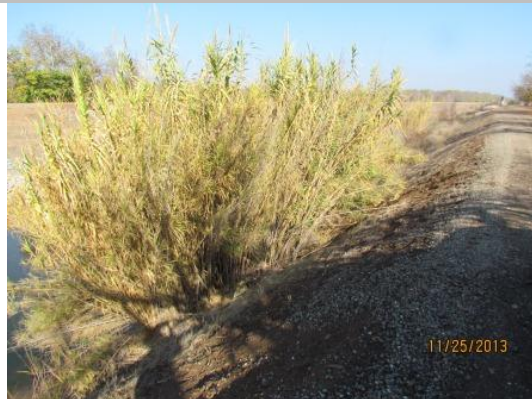
Photo 1 of 1 : FA_2020_NA0017_160_152_20200901_00067.jpg

LM Start	3.47	Rating **	M	Issue No.	152
LM End	3.53	Issue Type +	Ma	Location *	WS
Category	Earthen Levee			GPS Latitude/Longitude	
				Start	End
Item	Vegetation			38.021036 °	38.020402 °
				-121.061101 °	-121.061873 °
DWR ID	DWR_NA0017_16_f_2013_152				
Comment Code					
V2 : Remove the wild growth other than native grasses from the levee slopes.					
Inspector Comment					
Arundo was obstructing the inspection of the channel from the patrol road.

Arundo was found on the waterside toe of the levee looking upstream.

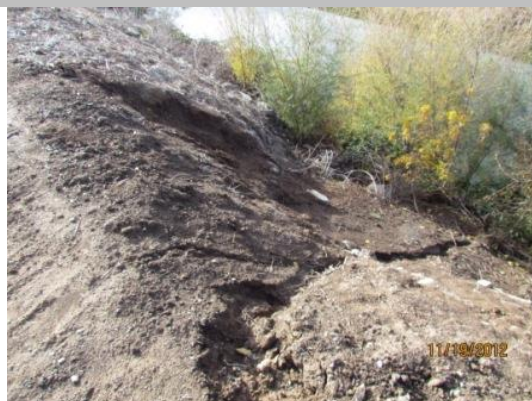
Photo 1 of 1 : FA_2020_NA0017_160_230_20200901_00081.jpg

LM Start	3.53	Rating **	A/W	Issue No.	230
LM End	3.53	Issue Type +	Ma	Location *	WS
Category	Earthen Levee			GPS Latitude/Longitude	
				Start	End
Item	Erosion / Bank Caving			38.020433 °	38.020433 °
				-121.061867 °	-121.061867 °
DWR ID	DWR_NA0017_16_f_2012_230				
Comment Code					
E1 : Note and monitor erosion site.					
Inspector Comment					
This portion of the levee is non-project. Therefore, an A/W rating was given.

Erosion was found on the waterside slope of the levee looking downstream.

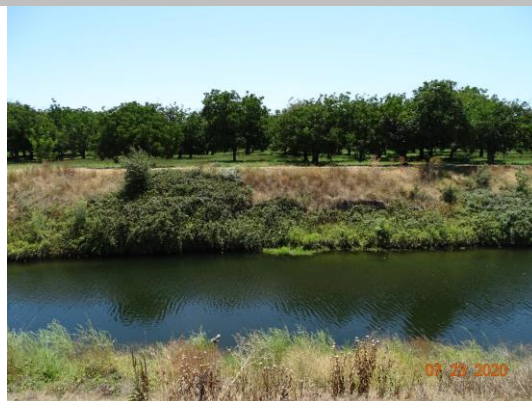
Photo 1 of 3 : SJR2019_NA0017U16RM19.29_01.JPG

LM Start	3.61	Rating **	A/W	Issue No.	47
LM End	3.61	Issue Type +	Ma	Location *	WS
Category	Supplemental			GPS Latitude/Longitude	
				Start	End
Item	DWR Erosion Survey			38.019642 °	38.019642 °
				-121.062917 °	-121.062917 °
DWR ID	NA0017U16RM19.29				
Comment Code					
Inspector Comment					
Site ID: NA0017U16RM19.29					
*This area is patrol road only and therefore the site is not rated					
07/23/2020: From 2015 to present, no significant changes were					
observed during the annual survey. The vegetation growth has					
increased.					
08/20/2014: A pocket erosion was found near the water's edge.

7/23/2020: View of the erosion from the opposite bank.

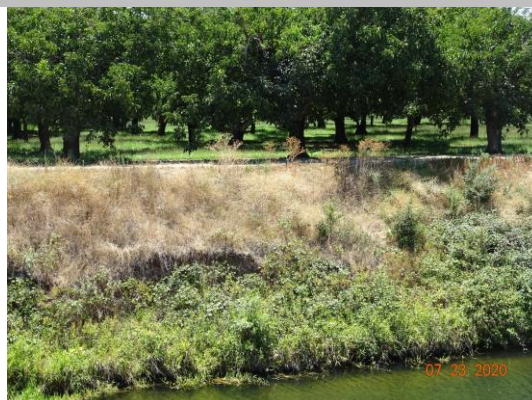
Photo 2 of 3 : SJR2019_NA0017U16RM19.29_03.JPG

7/23/2020: Close-up view of the erosion.

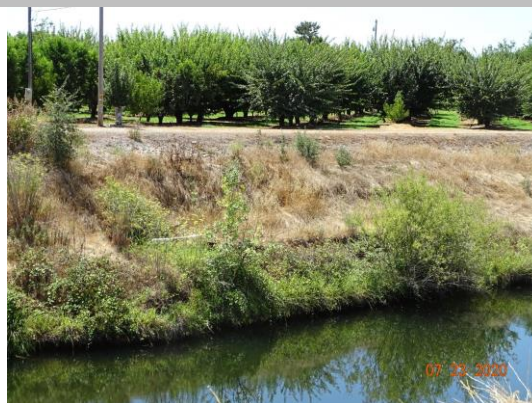
Photo 2 of 3 : SJR2019_NA0017U16RM19.18_03.JPG

7/23/2020: Close-up view of the erosion.

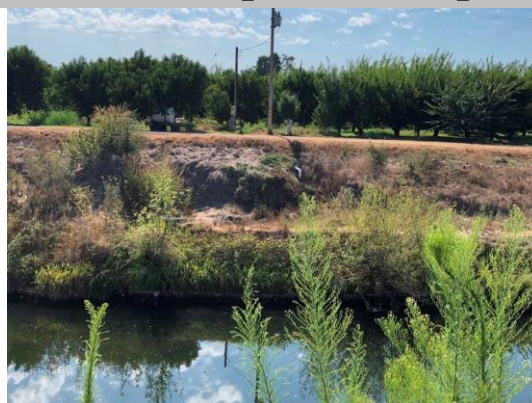
Photo 3 of 3 : SJR2019_NA0017U16RM19.18_5.JPG

8/28/2019: Front view of the erosion at the berm.

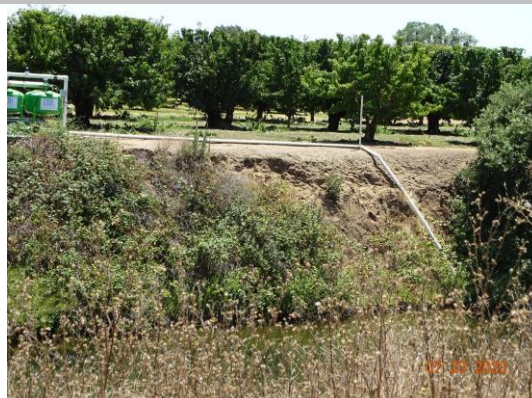
Photo 1 of 2 : SJR2019_NA0017U16RM18.69_02.JPG

*This area is patrol road only and therefore the site is not rated
07/23/2020: From 2018 to present, no significant changes were observed during the annual survey. The site is located just upstream of an irrigation pipe crossing (DSIDs 23328/24945).
08/30/2017: New erosion observed at the site, under the irrigation pipe.
08/16/2016: From 2013 to present, no significant changes were observed during the annual survey.
08/22/2012: An irrigation pipe is present at the site, but probably did not cause the erosion. There is no levee structure on site.

7/23/2020: Close-up view of the erosion.

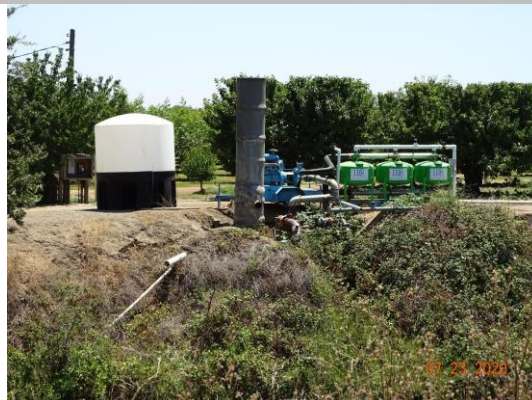
Photo 2 of 2 : SJR2019_NA0017U16RM18.69_03.JPG

7/23/2020: Another close-up view of the erosion.

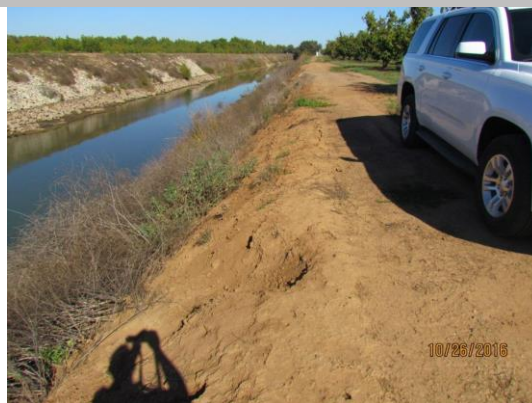
Photo 1 of 1 : FA_2020_NA0017_160_243_20200901_00086.jpg

LM Start	4.38	Rating **	A/W	Issue No.	243
LM End	4.38	Issue Type +	Ma	Location *	WS
Category	Earthen Levee			GPS Latitude/Longitude	
				Start	End
Item	Erosion / Bank Caving			38.009861 °	38.009861 °
				-121.069021 °	-121.069021 °
DWR ID	DWR_NA0017_16_f_2016_243				
Comment Code					
E1 : Note and monitor erosion site.					
Inspector Comment					
The erosion may cut into the access road if it is not repaired.

View of the erosion on the waterside slope of the levee. Fall 2016

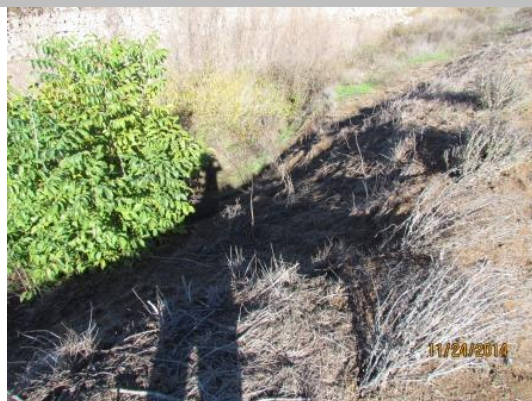
Photo 1 of 1 : FA_2020_NA0017_160_265_20200901_00094.jpg

LM Start	5.20	Rating **	A/W	Issue No.	265
LM End	5.20	Issue Type +	Ma	Location *	WS
Category	Earthen Levee			GPS Latitude/Longitude	
				Start	End
Item	Slope Stability			37.999537 °	37.999537 °
				-121.076133 °	-121.076133 °
DWR ID	DWR_NA0017_16_f_2014_265				
Comment Code					
S1 : Repair slope instability.					
Inspector Comment					
This portion of the levee is non-project. Therefore, an A/W rating was given.

A slope instability was found on the waterside slope of the levee looking upstream.

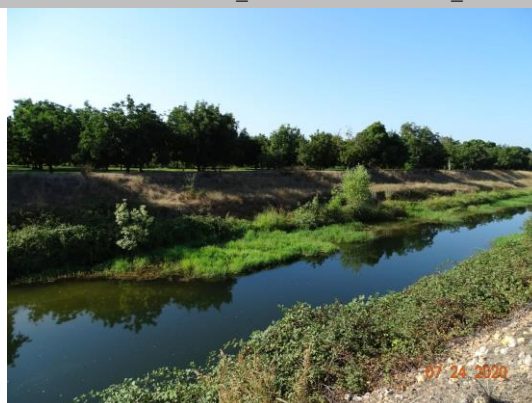
Photo 1 of 3 : SJR2019_NA0017U16RM17.81_01.JPG

LM Start	5.33	Rating **	A/W	Issue No.	11
LM End	5.38	Issue Type +	Ma	Location *	WS
Category	Supplemental			GPS Latitude/Longitude	
				Start	End
Item	DWR Erosion Survey			37.997720 °	37.997720 °
				-121.077807 °	-121.077807 °
DWR ID	NA0017U16RM17.81				
Comment Code					
Inspector Comment					
Site ID: NA0017U16RM17.81					
*This area is patrol road only and therefore the site is not rated					
07/24/2020: From 2013 to present, no significant changes were					
observed during the annual survey.					
08/22/2012: The site is located at the opposite river bank of E. Tobacco					
Road. There is no levee structure on site.

7/24/2020: View of the erosion from the opposite bank.

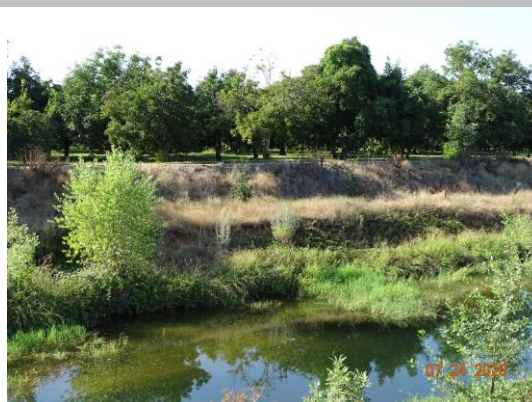
Photo 2 of 3 : SJR2019_NA0017U16RM17.81_02.JPG

7/24/2020: Close-up view of the erosion.

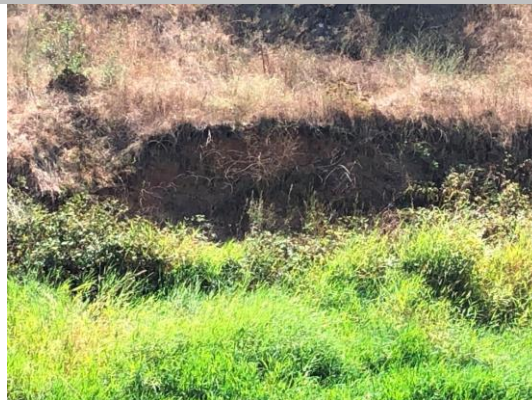
Photo 3 of 3 : SJR2019_NA0017U16RM17.81_5.JPG

8/28/2019: Close-up view of the erosion.

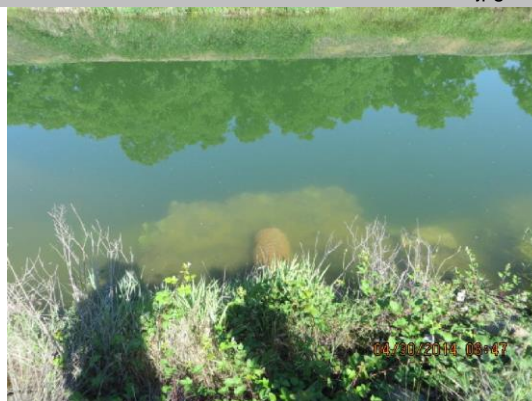
Photo 1 of 3 : UCIP_FA_2020_35686_64327.jpg

LM Start	5.48	Rating **	M	Issue No.	407	
LM End	5.48	Issue Type +	Ma	Location *		
Category	Supplemental			GPS Latitude/Longitude		
				Start		End
Item	DWR UCIP LMA Responsibility			37.996132 °		37.996132 °
				-121.079127 °		-121.079127 °
DWR ID	23332					
Comment Code						
Inspector Comment						
DS_ID:23332 FS_ID:35686 EP_NO: N/A Repair Type: Non-Urgent EVAL Issue: Crossing Status: Found UCIP Comments: Pipe appears abandoned and if so should be done so properly. LS of pipe is buried and WS is badly rusted. Pipe should be inspected internally. FIELD_STRUCT_DESC: *ABANDONED* 18-inch corrugated metal drainage pipe through the levee, 3 feet below the crown. Grout over pipe in channel with pipe open and visible in water at the WS toe. [Additional Reference(s): DWR Levee Log, 1992. USACE San Joaquin O&M Manual 611.1, Volume F, (HLM 5.69)]. FS Date: 4/30/2014

Pipe visible in water at WS toe.

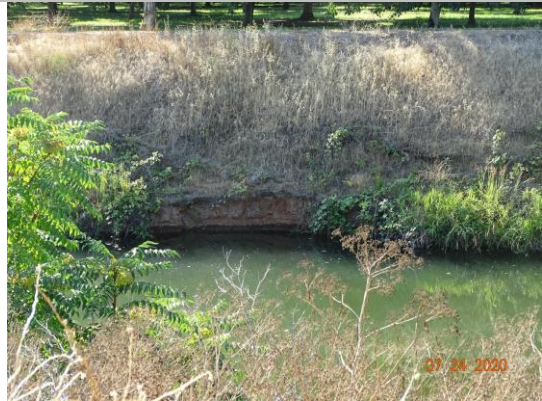
Photo 2 of 3 : SJR2019_NA0017U16RM17.27_01.JPG

7/24:2020: Close-up view of the erosion.

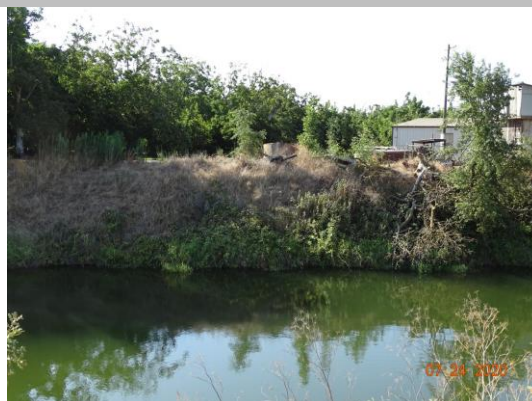
Photo 1 of 3 : SJR2019_NA0017U16RM17.11_01.JPG

LM Start	5.71	Rating **	A/W	Issue No.	49
LM End	5.72	Issue Type +	Ma	Location *	WS
Category	Supplemental			GPS Latitude/Longitude	
				Start	End
Item	DWR Erosion Survey			37.993525 °	37.993525 °
				-121.081679 °	-121.081679 °
DWR ID	NA0017U16RM17.11				
Comment Code					
Inspector Comment					
Site ID: NA0017U16RM17.11					
*This area is patrol road only and therefore the site is not rated					
07/24/2020: From 2015 to present, no significant changes were					
observed during the annual survey. The erosion is covered by dense					
vegetation.					
08/20/2014: The erosion is near a tree and probably has been made					
worse by the unstable bank slope.

7/24/2020: View of the erosion from the opposite bank.

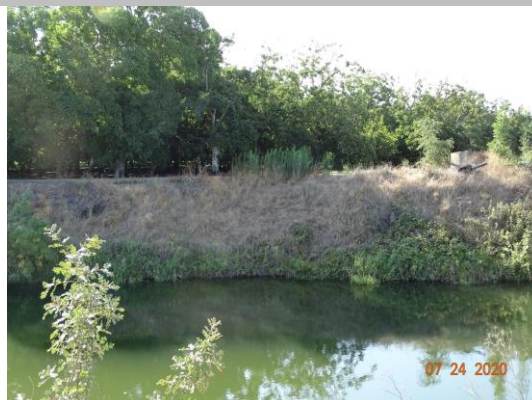
Photo 2 of 3 : SJR2019_NA0017U16RM17.11_02.JPG

7/24/2020: View of the erosion from the opposite bank.

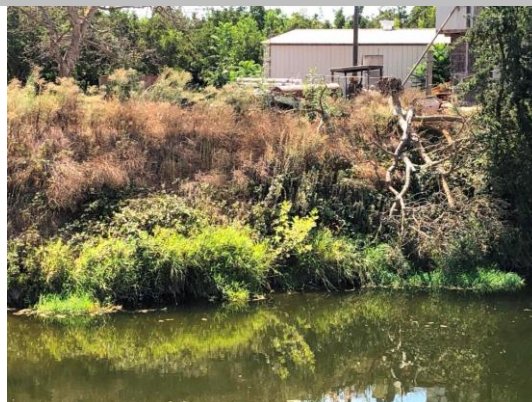
Photo 3 of 3 : SJR2019_NA0017U16RM17.11_4.JPG

8/28/2019: Close-up view of the erosion.

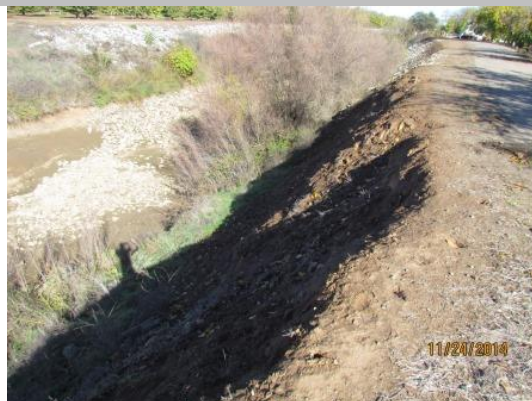
Photo 1 of 1 : FA_2020_NA0017_160_264_20200901_00093.jpg

LM Start	5.87	Rating **	A/W	Issue No.	264
LM End	5.87	Issue Type +	Ma	Location *	WS
Category	Earthen Levee			GPS Latitude/Longitude	
				Start	End
Item	Slope Stability			37.991628 °	37.991628 °
				-121.083312 °	-121.083312 °
DWR ID	DWR_NA0017_16_f_2014_264				
Comment Code					
S1 : Repair slope instability.					
Inspector Comment					
This portion of the levee is non-project. Therefore, an A/W rating was given.

Slope instability was found on the waterside of the levee looking upstream.

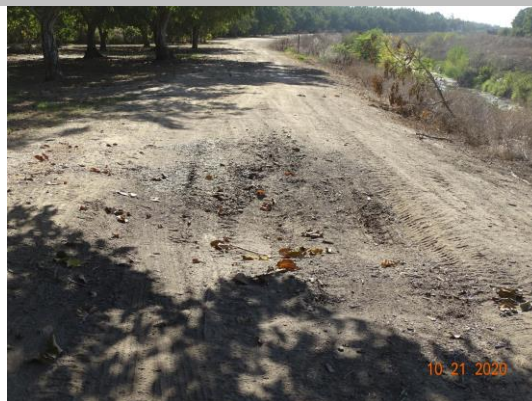
Photo 1 of 1 : FA_2020_NA0017_160_57_20201022_00357.jpg

LM Start	6.45	Rating **	U	Issue No.	57
LM End	6.45	Issue Type +	Ma	Location *	CR
Category	Earthen Levee			GPS Latitude/Longitude	
				Start	End
Item	Crown Surface / Depressions / Rutting			37.984692 °	37.984692 °
				-121.089201 °	-121.089201 °
DWR ID	DWR_NA0017_16_s_2018_57				
Comment Code					
C2 : Repair depressions or ruts in the crown or slope.					
Inspector Comment					
Repair depression on patrol road.

View of depression on crown surface. Fall 2020

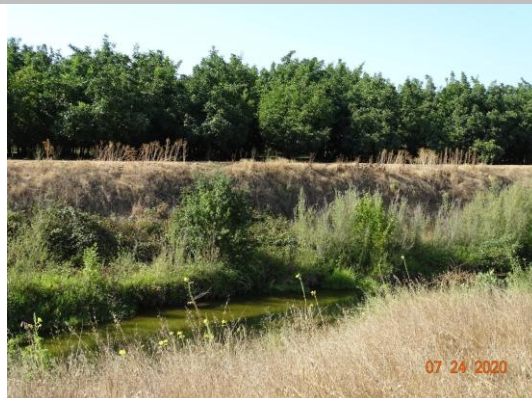
Photo 2 of 3 : SJR2019_NA0017U16RM16.27_02.JPG

7/24/2020: View of the erosion from the opposite bank.

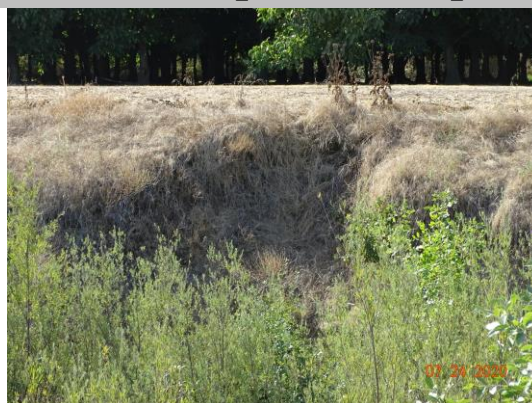
Photo 3 of 3 : SJR2019_NA0017U16RM16.27_06.JPG

7/24/2020: Close-up view of the erosion.

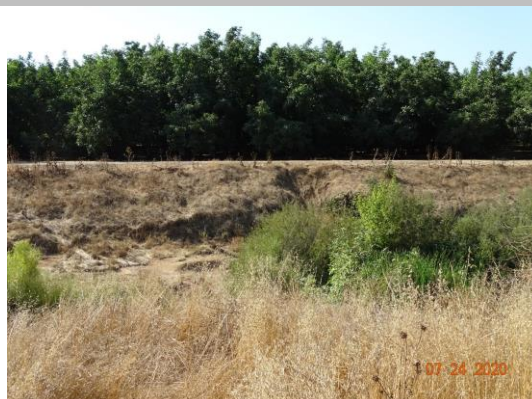
Photo 1 of 3 : SJR2019_NA0017U16RM16.15_02.JPG

*This area is patrol road only and therefore the site is not rated
07/24/2020: No changes observed since the previous inspection.
08/29/2019: There is no levee at the site. The erosion is likely caused by the rainfall runoff.

7/24/2020: View of the erosion from the opposite bank.

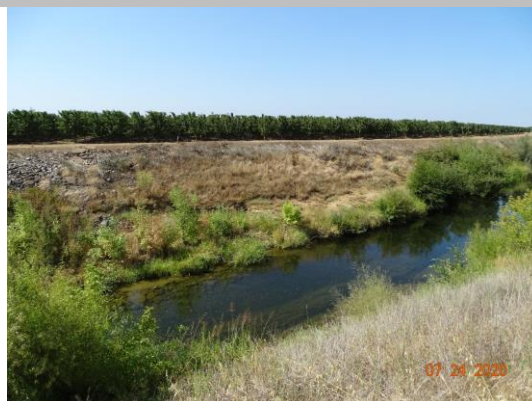
Photo 1 of 3 : SJR2019_NA0017U16RM15.57_02.JPG

*This area is patrol road only and therefore the site is not rated
07/24/2020: From 2013 to present, no significant changes were observed during the annual survey. Note: The site ID changed from NA0017U16RM10.82 to NA0017U16RM15.57 in 2014 to reflect the correct river mile.
09/12/2013: The site is located at immediately downstream of a levee segment protected by broken concrete. There is no levee structure on site.

7/24/2020: View of the erosion from the opposite bank.

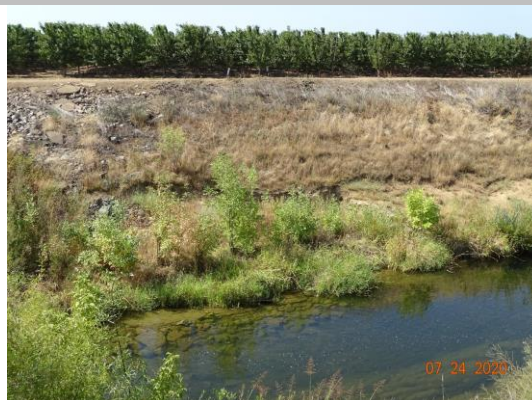
Photo 2 of 3 : SJR2019_NA0017U16RM15.57_03.JPG

7/24/2020: Close-up view of the erosion.

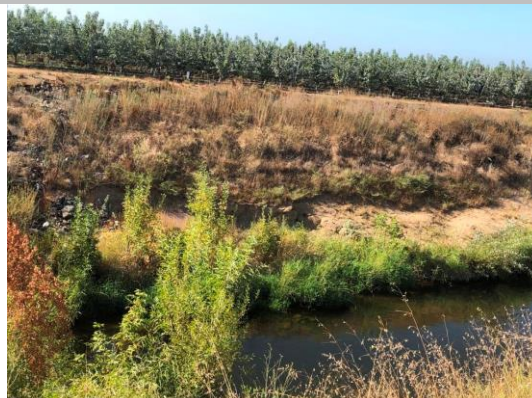
Photo 3 of 3 : SJR2019_NA0017U16RM15.57_5.JPG

8/29/2020: Close-up view of the erosion.

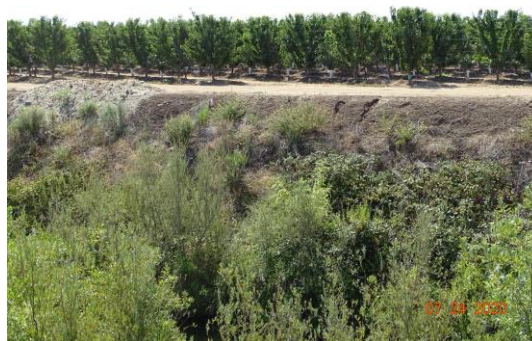
Photo 1 of 3 : SJR2019_NA0017U16RM15.45_03.JPG

7/24/2020: View of the erosion from the opposite bank.

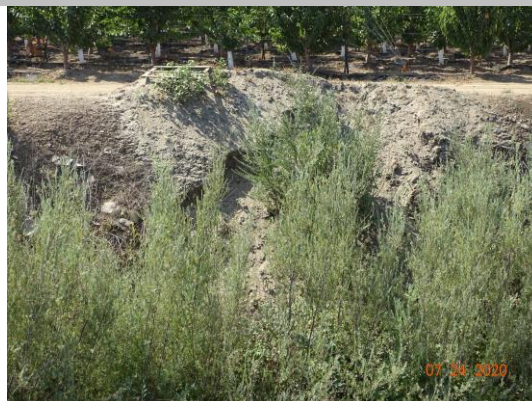
Photo 2 of 3 : SJR2019_NA0017U16RM15.45_04.JPG

7/24/2020: Close-up view of the eroding fill.

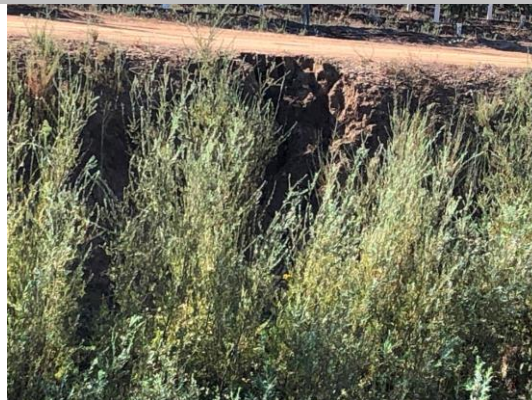
Photo 3 of 3 : SJR2019_DWR_NA0017_16_f_2015_237_2.JPG

8/27/2019: Close-up view of the erosion.

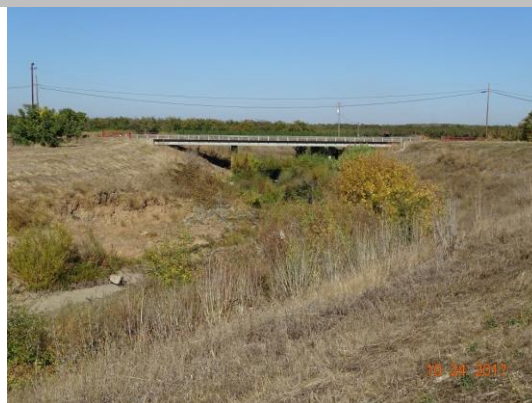
Photo 1 of 1 : FA_2020_NA0017_160_255_20200901_00091.jpg

LM Start	8.17	Rating **	A	Issue No.	255
LM End	8.17	Issue Type +	Ma	Location *	WS
Category	Rivers, Channels & Designated Floodways			GPS Latitude/Longitude	
				Start	End
Item	Vegetation & Obstructions			37.970427 °	37.970427 °
				-121.113623 °	-121.113623 °
DWR ID	DWR_NA0017_16_f_2017_255				
Comment Code					
Inspector Comment					
Woody vegetation may impede the flow of the channel at this location.

View of woody vegetation on the channel looking upstream. Fall 2017

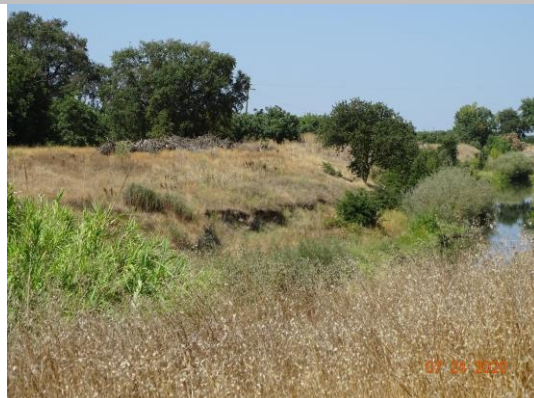
Photo 1 of 3 : SJR2019_NA0017U16RM14.48_02.JPG

LM Start	8.33	Rating **	A/W	Issue No.	14
LM End	8.40	Issue Type +	Ma	Location *	WS
Category	Supplemental			GPS Latitude/Longitude	
				Start	End
Item	DWR Erosion Survey			37.969213 °	37.969213 °
				-121.116574 °	-121.116574 °
DWR ID	NA0017U16RM14.48				
Comment Code					
Inspector Comment					
Site ID: NA0017U16RM14.48					
*This area is patrol road only and therefore the site is not rated					
07/24/2020: From 2013 to present, no significant changes were					
observed during the annual survey.					
08/22/2012: The erosion occurred on a berm of approximately 25 ft.					
wide. Site is covered with dense vegetation. There is no levee structure					
on site.

7/24/2020: View of the erosion from the opposite bank looking downstream.

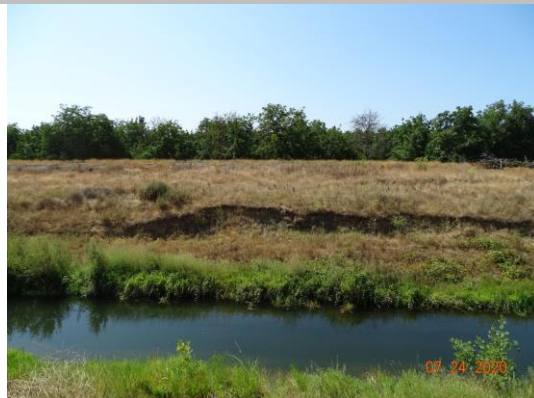
Photo 2 of 3 : SJR2019_NA0017U16RM14.48_03.JPG

7/24/2020: View of the erosion from the opposite bank.

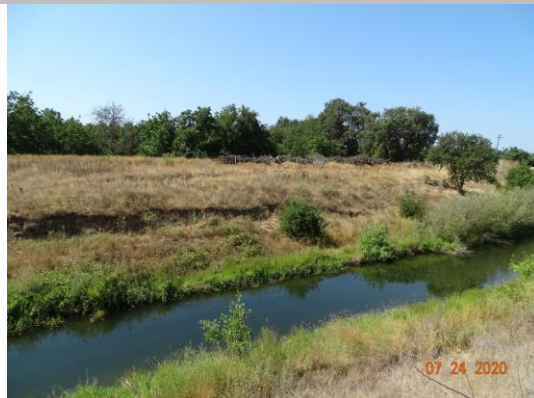
Photo 3 of 3 : SJR2019_NA0017U16RM14.48_04.JPG

7/24/2020: View of the erosion looking downstream.

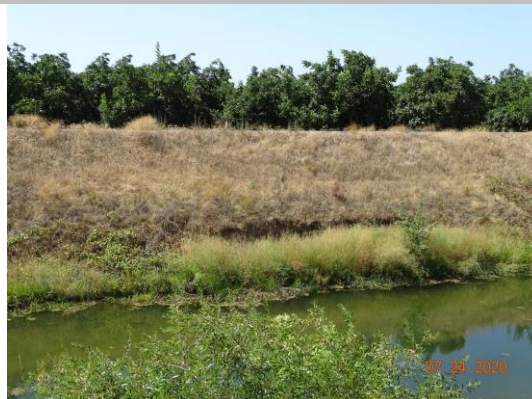
Photo 1 of 2 : SJR2019_NA0017U16RM13.86_02.JPG

*This area is patrol road only and therefore the site is not rated
07/24/2020: From 2013 to present, no significant changes were observed during the annual survey.
08/22/2012: Pocket erosion at the levee toe and slope. The erosion is covered with dense vegetation. There is no levee structure on site.

7/24/2020: View of the erosion from the opposite bank.

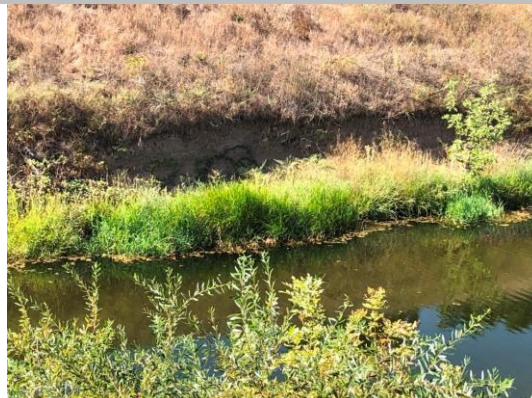
Photo 2 of 2 : SJR2019_NA0017U16RM13.86_2.jpg

8/29/2019: Close-up view of the erosion.

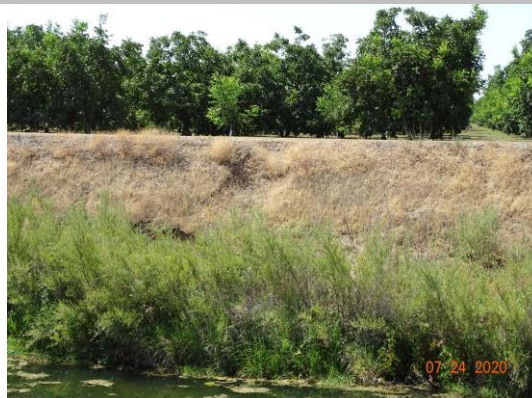
Photo 1 of 2 : SJR2019_NA0017U16RM13.85_01.JPG

LM Start	9.00	Rating **	A/W	Issue No.	30
LM End	9.00	Issue Type +	Ma	Location *	WS
Category	Supplemental			GPS Latitude/Longitude	
				Start	End
Item	DWR Erosion Survey			37.966585 °	37.966585 °
				-121.127388 °	-121.127388 °
DWR ID	NA0017U16RM13.85				
Comment Code					
Inspector Comment					
Site ID: NA0017U16RM13.85					
*This area is patrol road only and therefore the site is not rated					
07/24/2020: From 2014 to present, no significant changes were					
observed during the annual survey.					
09/12/2013: The erosion might have been caused by river flow					
combined with runoff. Dense vegetation is presents at the site. There is					
no levee structure on site.

7/24/2020: View of the erosion from the opposite bank.

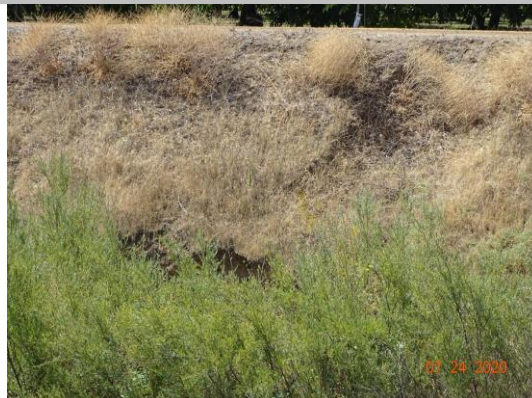
Photo 2 of 2 : SJR2019_NA0017U16RM13.85_02.JPG

7/24/2020: Close-up view of the erosion.

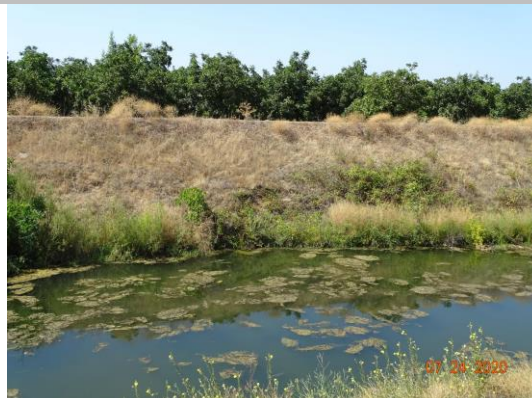
Photo 1 of 1 : SJR2019_NA0017U16RM13.83_04.JPG

LM Start	9.02	Rating **	A/W	Issue No.	46
LM End	9.02	Issue Type +	Ma	Location *	WS
Category	Supplemental			GPS Latitude/Longitude	
				Start	End
Item	DWR Erosion Survey			37.966639 °	37.966639 °
				-121.127716 °	-121.127716 °
DWR ID	NA0017U16RM13.83				
Comment Code					
Inspector Comment					
Site ID: NA0017U16RM13.83					
*This area is patrol road only and therefore the site is not rated					
7/24/2020: The site was discovered during the 2020 field survey. The					
erosion has cut into the bank. Medium to dense vegetation is covering					
the scarp and slope.

7/24/2020: View from the opposite bank. The erosion has cut into the bank.

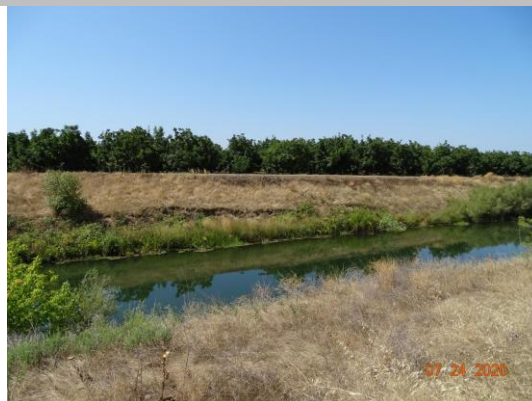
Photo 1 of 2 : SJR2019_NA0017U16RM13.72_02.JPG

LM Start	9.11	Rating **	A/W	Issue No.	21
LM End	9.13	Issue Type +	Ma	Location *	WS
Category	Supplemental			GPS Latitude/Longitude	
				Start	End
Item	DWR Erosion Survey			37.966922 °	37.966922 °
				-121.129533 °	-121.129533 °
DWR ID	NA0017U16RM13.72				
Comment Code					
Inspector Comment					
Site ID: NA0017U16RM13.72					
*This area is patrol road only and therefore the site is not rated					
07/24/2020: From 2013 to present, no significant changes were observed during the annual survey.					
08/22/2012: The erosion is covered with dense vegetation. There is no levee structure on site.

7/24/2020: View of the erosion from the opposite bank.
