**Flood Control Project Maintenance
Levee Inspections**

Maintenance Issue Types Only, Levee Inspection Report By Mile - Fall 2020

San Joaquin County Flood Control and Water Conservation District

Waterway	Bank	Unit Miles	Inspection Start/End	Inspector
Unit No. 01 Littlejohn Creek	Left	2.59	10/20/2020 10/20/2020	Alberto De Leon

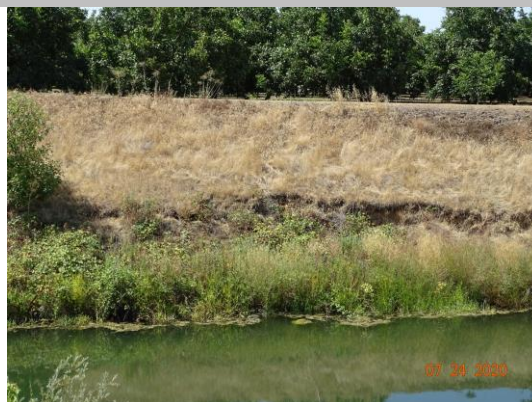
Photo 2 of 2 : SJR2019_NA0017U16RM13.72_03.JPG

7/24/2020: Close-up view of the erosion.

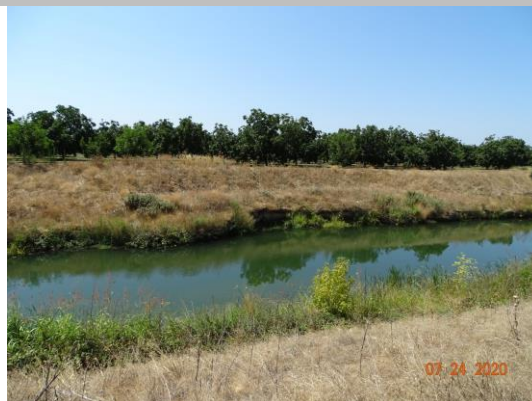
Photo 1 of 2 : SJR2019_NA0017U16RM13.53_01.JPG

LM Start	9.31	Rating **	A/W	Issue No.	22
LM End	9.33	Issue Type +	Ma	Location *	WS
Category	Supplemental			GPS Latitude/Longitude	
				Start	End
Item	DWR Erosion Survey			37.966772 °	37.966772 °
				-121.133071 °	-121.133071 °
DWR ID	NA0017U16RM13.53				
Comment Code					
Inspector Comment					
Site ID: NA0017U16RM13.53					
*This area is patrol road only and therefore the site is not rated					
07/24/2020: From 2013 to present, no significant changes were					
observed during the annual survey.					
08/22/2012: The erosion is on berm. The berm width is estimated.					
There is no levee structure on site.

7/24/2020: View of the erosion from the opposite bank.

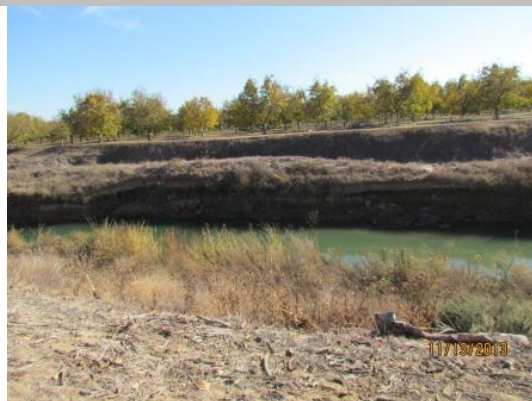
Photo 1 of 1 : FA_2020_NA0017_160_28_20200901_00015.jpg

LM Start	9.48	Rating **	A/W	Issue No.	28
LM End	9.48	Issue Type +	Ma	Location *	WS
Category	Earthen Levee			GPS Latitude/Longitude	
				Start	End
Item	Erosion / Bank Caving			37.966239 °	37.966239 °
				-121.136172 °	-121.136172 °
DWR ID	DWR_NA0017_16_f_2013_28				
Comment Code					
E1 : Note and monitor erosion site.					
Inspector Comment					
Erosion was found on the waterside toe of the levee.

View of the erosion on the waterside toe of the levee looking from the opposite side of the levee.

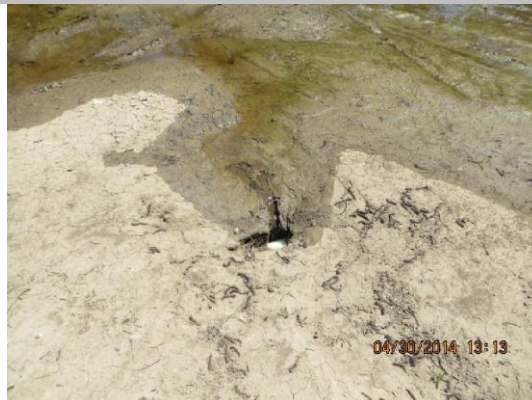
Photo 1 of 3 : UCIP_FA_2020_36144_65406.jpg

LM Start	9.48	Rating **	M	Issue No.	422
LM End	9.48	Issue Type +	Ma	Location *	
Category	Supplemental			GPS Latitude/Longitude	
				Start	End
Item	DWR UCIP LMA Responsibility			37.965880 °	37.965880 °
				-121.135897 °	-121.135897 °
DWR ID	23344				
Comment Code					
Inspector Comment					
DS_ID:23344					
FS_ID:36144					
EP_NO: N/A					
Repair Type: Non-Urgent					
EVAL Issue:					
Crossing Status: Found					
UCIP Comments: Inlet appears to be buried with soil on LS. Pipe heavily corroded at outlet on WS toe. Good candidate for video inspection.					
FIELD_STRUCT_DESC: 18-inch corrugated metal drainage pipe, 3.5 feet below the roadway. Grouted spillway and inlet. [Additional Reference(s): DWR Levee Log, 1992. USACE San Joaquin O&M Manual 611.1, Volume F, (HLM 9.77)].					
FS Date: 4/30/2014

Inlet on LS shoulder buried in soil.

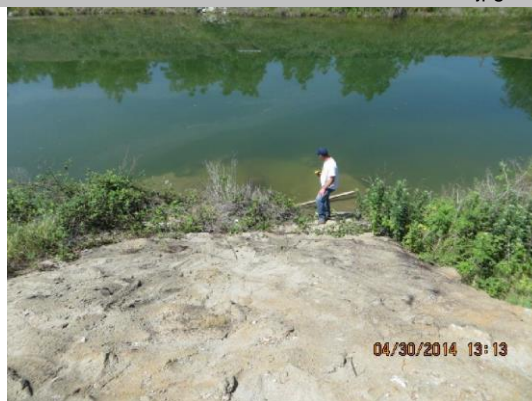
Photo 2 of 3 : UCIP_FA_2020_36144_65405.jpg

Grout over pipe on WS slope with pipe visible in water at WS toe.

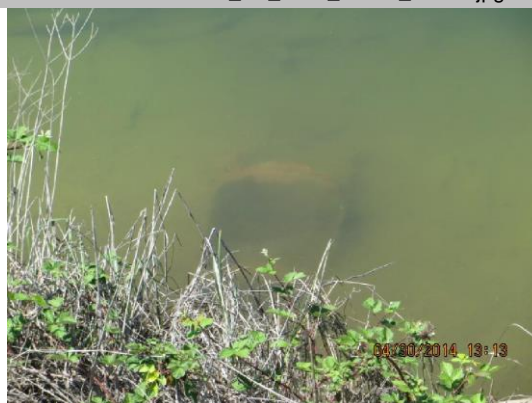
Photo 3 of 3 : UCIP_FA_2020_36144_65404.jpg

Pipe completely rusted through at outlet on WS toe.

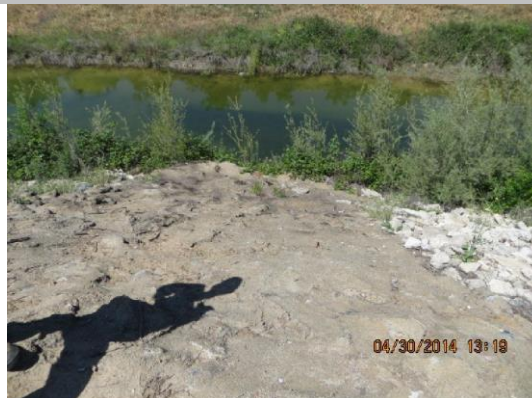
Photo 1 of 3 : UCIP_FA_2020_36145_65409.jpg

LM Start	9.78	Rating **	M	Issue No.	423	
LM End	9.78	Issue Type +	Ma	Location *		
Category	Supplemental			GPS Latitude/Longitude		
				Start	End	
Item	DWR UCIP LMA Responsibility			37.964912 °	37.964912 °	
				-121.140827 °	-121.140827 °	
DWR ID	23345					
Comment Code						
Inspector Comment						
DS_ID:23345						
FS_ID:36145						
EP_NO: N/A						
Repair Type: Non-Urgent						
EVAL Issue:						
Crossing Status: Found						
UCIP Comments: Inlet on LS buried in soil.						
FIELD_STRUCT_DESC: 18-inch corrugated metal drainage pipe						
through the levee, 3.5 feet below the crown. Grouted spillway and inlet.						
[Additional Reference(s): DWR Levee Log, 1992. USACE San Joaquin						
O&M Manual 611.1, Volume F, (HLM 10.07)].						
FS Date: 4/30/2014

Grout over pipe on WS slope.

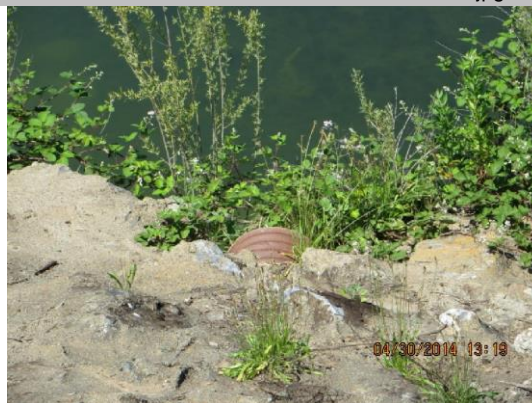
Photo 2 of 3 : UCIP_FA_2020_36145_65408.jpg

Pipe at outlet on WS toe.

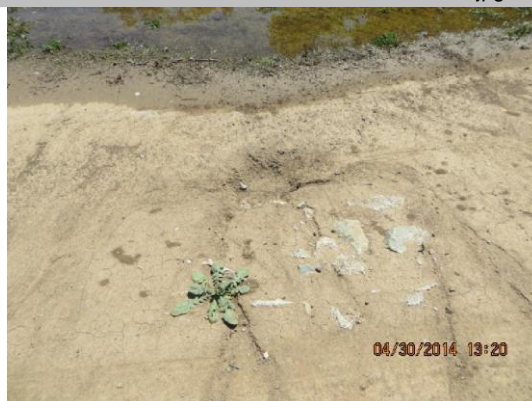
Photo 3 of 3 : UCIP_FA_2020_36145_65407.jpg

Inlet appears to be buried in soil on LS shoulder.

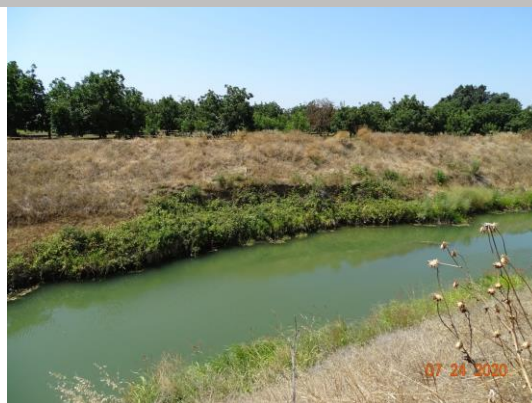
Photo 1 of 2 : SJR2019_NA0017U16RM12.95_02.JPG

LM Start	9.86	Rating **	A/W	Issue No.	24
LM End	9.88	Issue Type +	Ma	Location *	WS
Category	Supplemental		GPS Latitude/Longitude		
			Start	End	
Item	DWR Erosion Survey		37.964735 °	37.964735 °	
			-121.142503 °	-121.142503 °	
DWR ID	NA0017U16RM12.95

*This area is patrol road only and therefore the site is not rated
07/24/2020: From 2013 to present, no significant changes were observed during the annual survey.

7/24/2020: View of the erosion from the opposite bank.

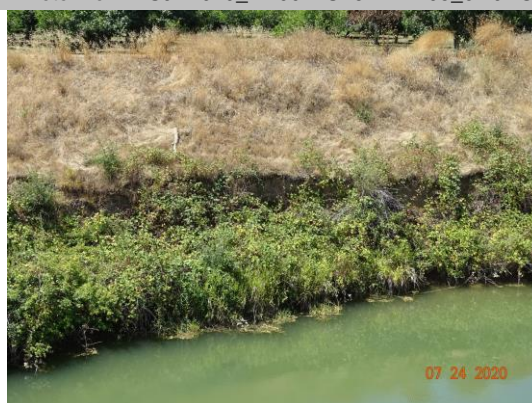
Photo 2 of 2 : SJR2019_NA0017U16RM12.95_04.JPG

7/24/2020: Close-up view of the erosion.

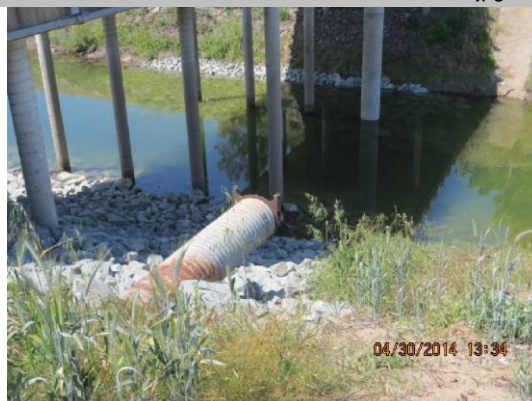
Photo 1 of 3 : UCIP_FA_2020_36163_65442.jpg

LM Start	10.20	Rating **	M	Issue No.	425
LM End	10.20	Issue Type +	Ma	Location *	
Category	Supplemental			GPS Latitude/Longitude	
				Start	End
Item	DWR UCIP LMA Responsibility			37.964670 °	37.964670 °
				-121.148455 °	-121.148455 °
DWR ID	23347				
Comment Code					
Inspector Comment					
DS_ID:23347 FS_ID:36163 EP_NO: N/A Repair Type: Non-Urgent EVAL Issue: Crossing Status: Found UCIP Comments: Heavy sediment buildup at inlet on LS toe. FIELD_STRUCT_DESC: 18-inch corrugated metal drainage pipe through the levee, 5.5 feet below the crown. Concrete U-shaped headwall on the landside (LS). Flap gate on the waterside (WS) end. [Additional Reference(s): DWR Levee Log, 1992. USACE San Joaquin O&M Manual 611.1, Volume F, (HLM 10.50)]. FS Date: 4/30/2014

Pipe and flapgate visible on WS slope.

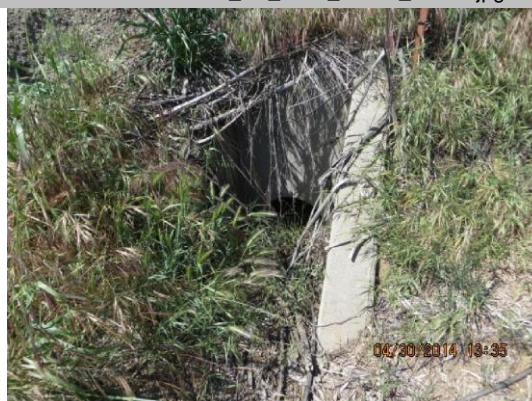
Photo 3 of 3 : UCIP_FA_2020_36163_65440.jpg

Headwall and pipe with heavy sediment buildup on LS toe.

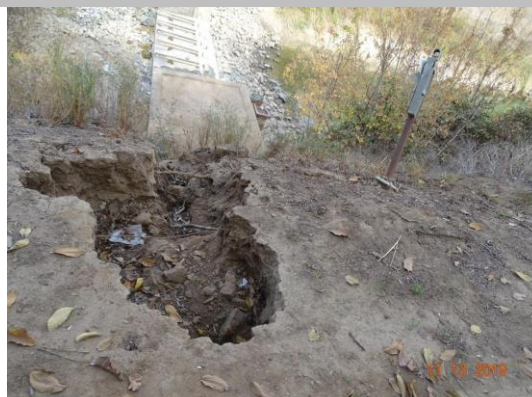
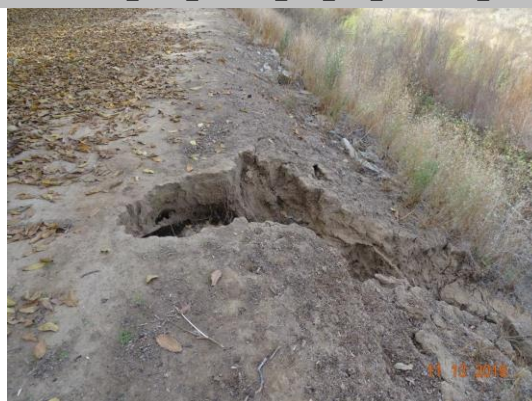
Photo 1 of 2 : FA_2020_NA0017_160_288_20200901_00106.jpg

LM Start	10.57	Rating **	M	Issue No.	288
LM End	10.57	Issue Type +	Ma	Location *	WS
Category	Earthen Levee			GPS Latitude/Longitude	
				Start	End
Item	Erosion / Bank Caving			37.963542 °	37.963542 °
				-121.155111 °	-121.155111 °
DWR ID	DWR_NA0017_16_f_2019_288				
Comment Code					
E2 : Schedule repair of erosion site prior to the next inspection.					
Inspector Comment					
Erosion may cut into patrol access road.

View of erosion/bank caving on waterside bank. Fall 2019

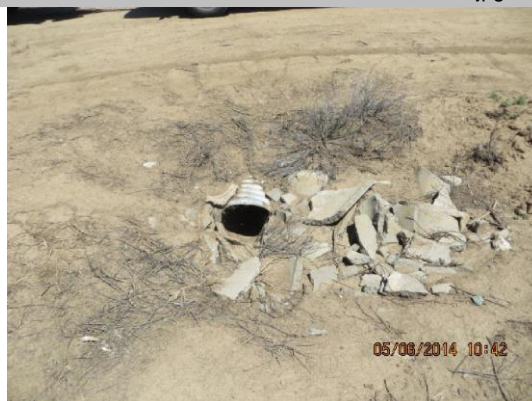
Photo 1 of 2 : UCIP_FA_2020_36186_65505.jpg

LM Start	11.08	Rating **	A/W	Issue No.	434	
LM End	11.08	Issue Type +	Ma	Location *		
Category	Supplemental			GPS Latitude/Longitude		
				Start	End	
Item	DWR UCIP LMA Responsibility			37.960565 °	37.960565 °	
				-121.163287 °	-121.163287 °	
DWR ID	23354					
Comment Code						
Inspector Comment						
DS_ID:23354						
FS_ID:36186						
EP_NO: N/A						
Repair Type: No Action Needed						
EVAL Issue:						
Crossing Status: Found						
UCIP Comments:						
FIELD_STRUCT_DESC: 18-inch corrugated metal drainage pipe						
through the levee, 3.5 feet below the roadway. Grouted spillway.						
[Additional Reference(s): DWR Levee Log, 1992. USACE San Joaquin						
O&M Manual 611.1, Volume F, (HLM 11.41)].						
FS Date: 5/6/2014

Pipe at inlet on LS toe.

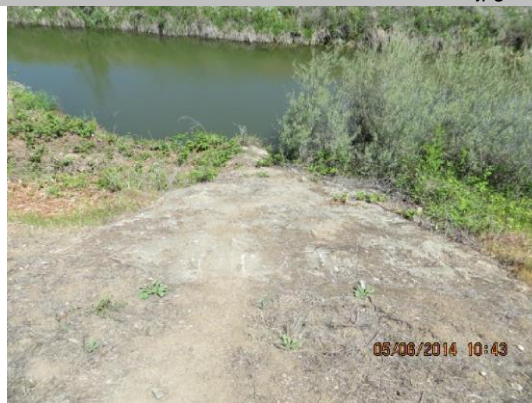
Photo 2 of 2 : UCIP_FA_2020_36186_65504.jpg

Grout over pipe on WS slope.

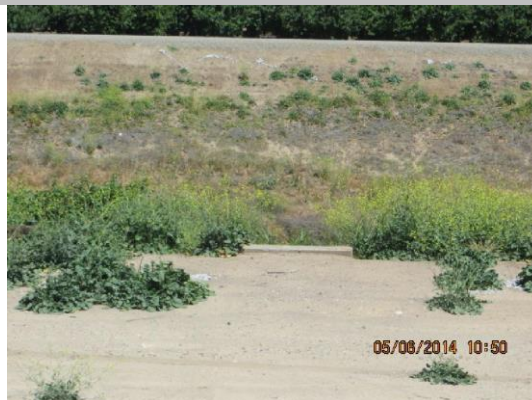
Photo 2 of 3 : UCIP_FA_2020_36187_65507.jpg

Pipe, flapgate, and headwall visible on WS shoulder.

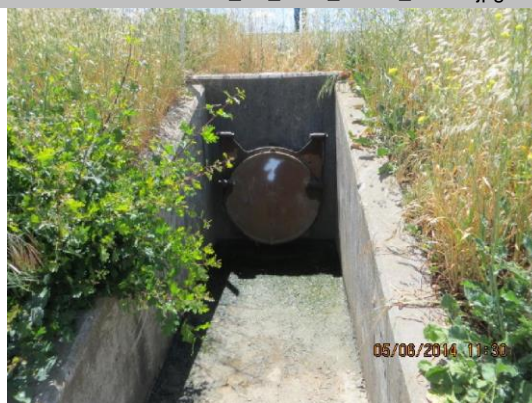
Photo 3 of 3 : UCIP_FA_2020_36208_65569.jpg

Pipe, headwall, and flapgate on WS slope.

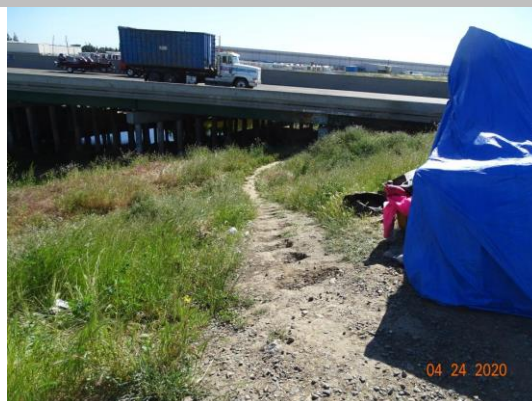
Photo 1 of 1 : FA_2020_NA0017_160_316_20200901_00116.jpg

LM Start	16.32	Rating **	U	Issue No.	316
LM End	16.33	Issue Type +	Ma	Location *	WS
Category	Earthen Levee			GPS Latitude/Longitude	
				Start	End
Item	Slope Stability			37.981633 °	37.981711 °
				-121.250452 °	-121.250620 °
DWR ID	DWR_NA0017_16_f_2019_316				
Comment Code					
S2 : Repair the levee slope damaged by foot traffic and prevent access where possible.					
Inspector Comment					
Foot path cutting into waterside slope.

View of foot path cutting into waterside slope. Spring 2020

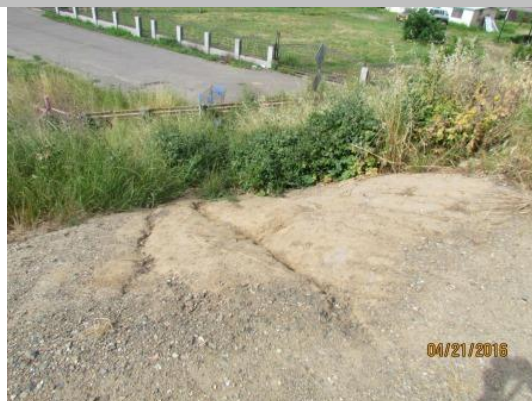
Photo 1 of 1 : FA_2020_NA0017_160_293_20200901_00108.jpg

LM Start	17.14	Rating **	M	Issue No.	293
LM End	17.14	Issue Type +	Ma	Location *	LS
Category	Earthen Levee			GPS Latitude/Longitude	
				Start	End
Item	Slope Stability			37.987210 °	37.987210 °
				-121.263501 °	-121.263501 °
DWR ID	DWR_NA0017_16_s_2016_293				
Comment Code					
S2 : Repair the levee slope damaged by foot traffic and prevent access where possible.					
Inspector Comment					
Landside slope erosion caused by foot traffic.

View of an erosion on the landside slope of the levee.

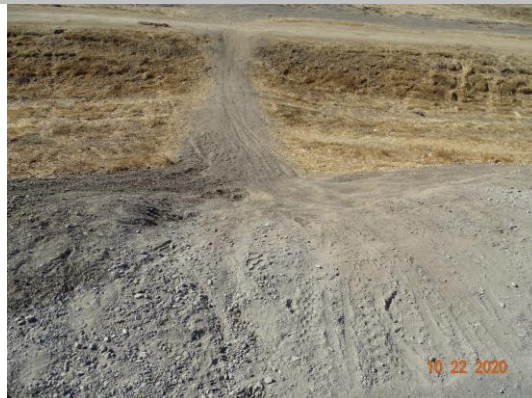
Photo 1 of 1 : FA_2020_NA0017_160_358_20201022_00363.jpg

LM Start	17.32	Rating **	M	Issue No.	358
LM End	17.32	Issue Type +	Ma	Location *	LS
Category	Earthen Levee			GPS Latitude/Longitude	
				Start	End
Item	Slope Stability			37.988432 °	37.988432 °
				-121.266343 °	-121.266343 °
DWR ID	DWR_NA0017_16_s_2020_358				
Comment Code					
S2 : Repair the levee slope damaged by foot traffic and prevent access where possible.					
Inspector Comment

View of foot path on landside slope caused by pedestrian traffic. Fall 2020

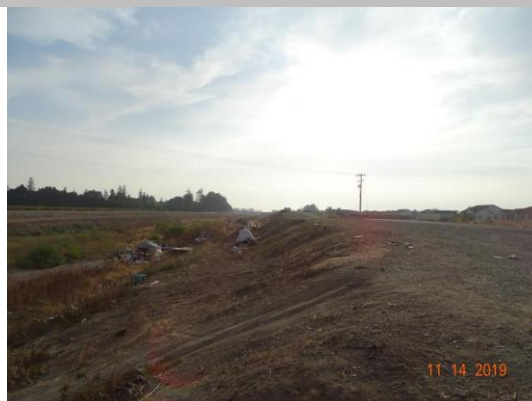
Photo 1 of 1 : FA_2020_NA0017_160_328_20200901_00118.jpg

LM Start	17.87	Rating **	A/W	Issue No.	328
LM End	17.89	Issue Type +	Ma	Location *	WS
Category	Earthen Levee			GPS Latitude/Longitude	
				Start	End
Item	Slope Stability			37.992220 °	37.992369 °
				-121.275317 °	-121.275637 °
DWR ID	DWR_NA0017_16_f_2019_328				
Comment Code					
S2 : Repair the levee slope damaged by foot traffic and prevent access where possible.					
Inspector Comment					
Foot path cutting into waterside slope.

View of foot path cutting into waterside slope. Fall 2019

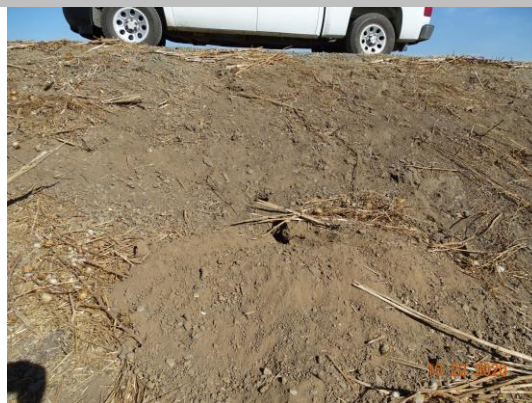
Photo 1 of 1 : FA_2020_NA0017_160_309_20201022_00364.jpg

LM Start	18.38	Rating **	M	Issue No.	309
LM End	18.38	Issue Type +	Ma	Location *	LS
Category	Earthen Levee			GPS Latitude/Longitude	
				Start	End
Item	Animal Control			37.992845 °	37.992845 °
				-121.283845 °	-121.283845 °
DWR ID	DWR_NA0017_16_f_2018_309				
Comment Code					
A1 : Exterminate rodents and backfill and compact or grout burrows.					
Inspector Comment

View of animal burrow on landside slope. Fall 2020

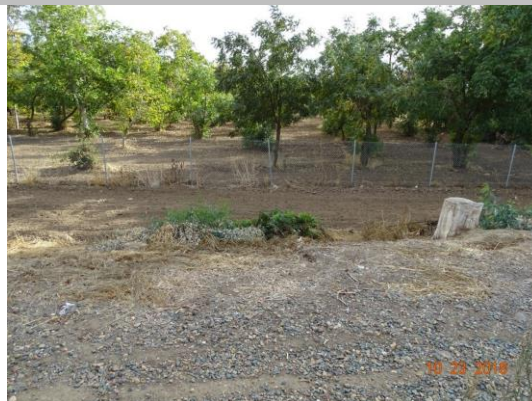
Photo 1 of 1 : FA_2020_NA0017_160_310_20200901_00113.jpg

LM Start	19.15	Rating **	N	Issue No.	310
LM End	19.15	Issue Type +	Ma	Location *	LS
Category	Earthen Levee			GPS Latitude/Longitude	
				Start	End
Item	Trim / Thin Trees			37.991113 °	37.991113 °
				-121.297598 °	-121.297598 °
DWR ID	DWR_NA0017_16_f_2018_310				
Comment Code					
T5 : Tree stumps.					
Inspector Comment

View of tree stumps on the landside slope (October 2018).

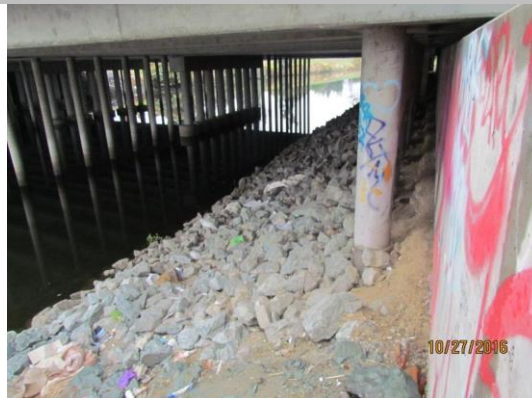
Photo 1 of 2 : FA_2020_NA0017_160_48_20200901_00027.jpg

LM Start	22.04	Rating **	A/W	Issue No.	48
LM End	22.04	Issue Type +	Ma	Location *	WS
Category	Earthen Levee			GPS Latitude/Longitude	
				Start	End
Item	Erosion / Bank Caving			37.978697 °	37.978697 °
				-121.341581 °	-121.341581 °
DWR ID	DWR_NA0017_16_s_2012_48				
Comment Code					
E1 : Note and monitor erosion site.					
Inspector Comment					
Caltrans repaired the issue. (Permit # 18562) Another repair might be needed if it deteriorates.

View of the riprap on the waterside slope of the levee. Fall 2016

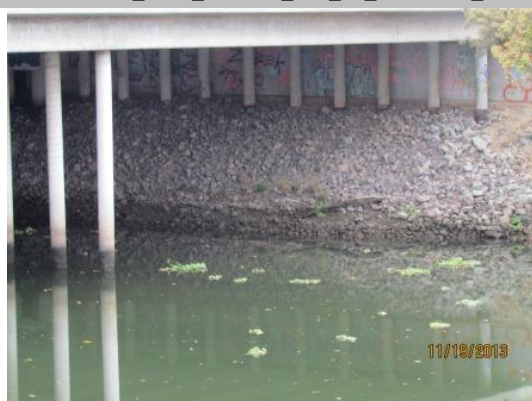
Photo 2 of 2 : FA_2020_NA0017_160_48_20200901_00028.jpg

Picture of erosion was found on the waterside toe of the levee looking from the opposite side of the levee. Fall 2013

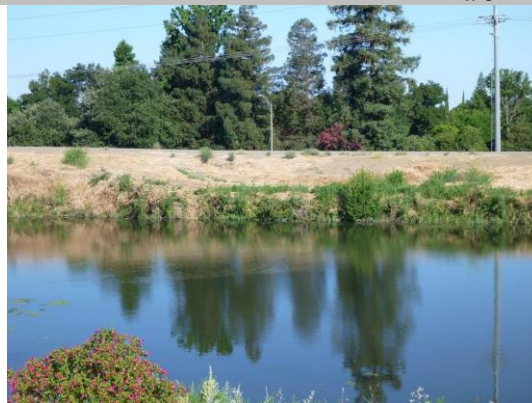
Photo 1 of 1 : LEVAL_FA_2020_474_2234.jpg

LM Start	22.19	Rating **	A/W	Issue No.	244	
LM End	22.19	Issue Type +	Ma	Location *	WS	
Category	Earthen Levee			GPS Latitude/Longitude		
				Start		End
Item	Erosion / Bank Caving			37.977185 °		37.977185 °
				-121.343687 °		-121.343687 °
DWR ID	LMA-301					
Comment Code						
E1 : Note and monitor erosion site.						
Inspector Comment						
2017 strom damage site, ID No. 474, LMA-301. Erosion along the left bank of the waterside slope.

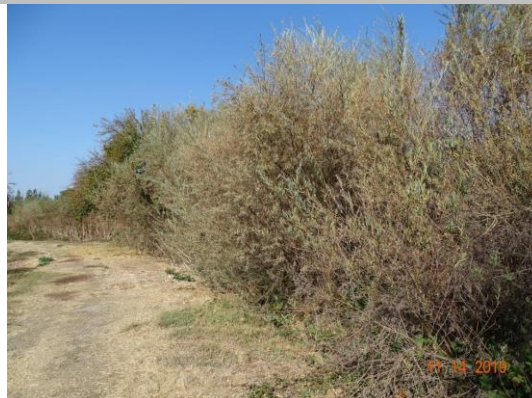
Photo 1 of 1 : FA_2020_NA0017_160_2_20200901_00001.jpg

LM Start	22.85	Rating **	U	Issue No.	2
LM End	23.47	Issue Type +	Ma	Location *	WS
Category	Earthen Levee			GPS Latitude/Longitude	
				Start	End
Item	Vegetation			37.969831 °	37.966144 °
				-121.350847 °	-121.360210 °
DWR ID	DWR_NA0017_16_s_2012_2				
Comment Code					
V2 : Remove the wild growth other than native grasses from the levee slopes.					
Inspector Comment

View of vegetation on waterside slope. Fall 2019

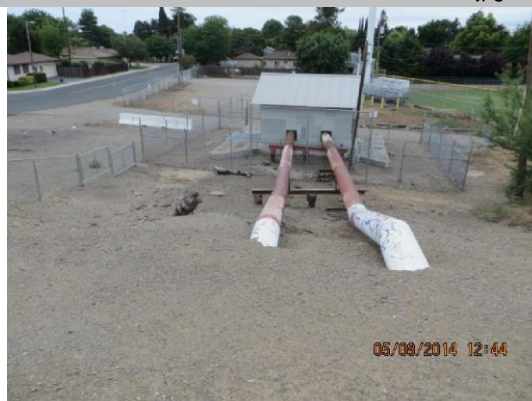
Photo 2 of 2 : UCIP_FA_2020_37423_67880.jpg

Pipe and pumphouse visible on LS toe.

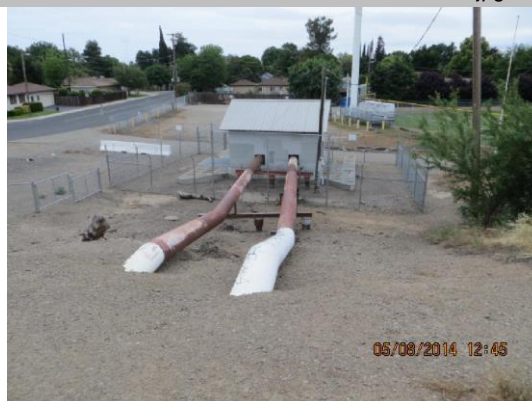
Photo 2 of 2 : UCIP_FA_2020_37424_67882.jpg

Pipe and pumphouse on LS toe.

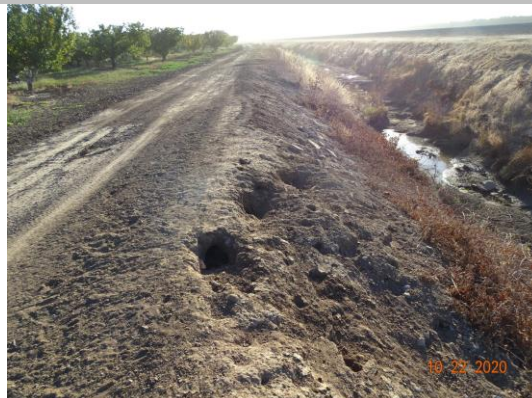
Photo 1 of 1 : FA_2020_NA0017_161_10_20201022_00011.jpg

LM Start	0.06	Rating **	U	Issue No.	10
LM End	0.06	Issue Type +	Ma	Location *	WS
Category	Earthen Levee		GPS Latitude/Longitude		
			Start	End	
Item	Animal Control		37.960241 °	37.960241 °	
			-121.162373 °	-121.162373 °	
DWR ID	DWR_NA0017_17_f_2019_10				
Comment Code					
A3 : No rodents visible, but rodent burrows visible; need to backfill and compact or grout burrows.					
Inspector Comment

View of large animal burrows on waterside slope. Fall 2020

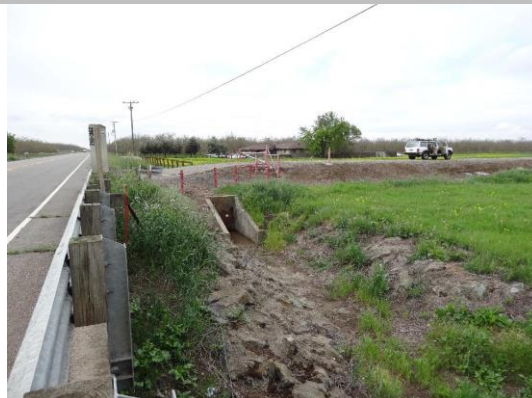
Photo 1 of 3 : UCIP_FA_2020_33112_59886.jpg

WS view: overview of pipe culvert and grouted riprap spillway.

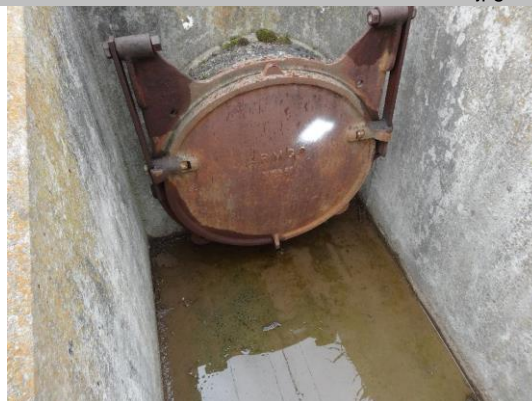
Photo 2 of 3 : UCIP_FA_2020_33112_59885.jpg

WS view: close view of CM pipe, flapgate, and concrete headwall.

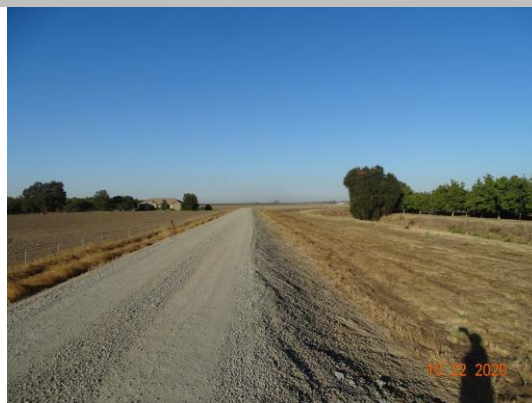
Photo 1 of 1 : FA_2020_NA0017_162_7_20201022_00013.jpg

LM Start	0.28	Rating **	A	Issue No.	7
LM End	0.91	Issue Type +	Ma	Location *	WS
Category	Earthen Levee			GPS Latitude/Longitude	
				Start	End
Item	Vegetation			37.958662 °	37.960326 °
				-121.153018 °	-121.164246 °
DWR ID	DWR_NA0017_18_f_2020_7				
Comment Code					
V1 : Control annual grass and weeds on the levee slopes and easements.					
Inspector Comment					
The annual vegetation is well maintained.

Typical view of vegetation on waterside slope. Fall 2020

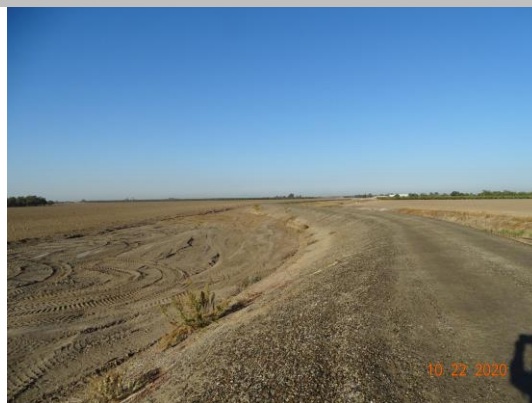
Photo 1 of 1 : FA_2020_NA0017_162_8_20201022_00014.jpg

LM Start	0.29	Rating **	A	Issue No.	8
LM End	0.91	Issue Type +	Ma	Location *	LS
Category	Earthen Levee			GPS Latitude/Longitude	
				Start	End
Item	Vegetation			37.958655 °	37.960327 °
				-121.153316 °	-121.164246 °
DWR ID	DWR_NA0017_18_f_2020_8				
Comment Code					
V1 : Control annual grass and weeds on the levee slopes and easements.					
Inspector Comment					
The annual vegetation is well maintained.

Typical view of vegetation on landside slope. Fall 2020

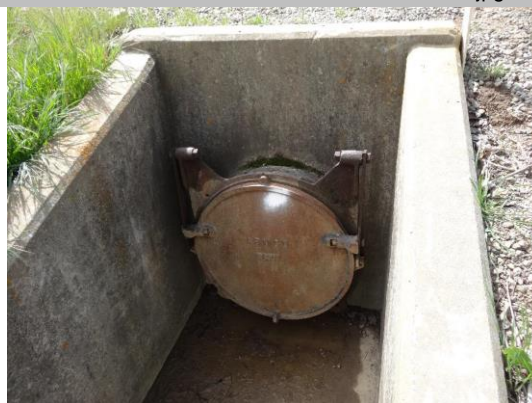
Photo 1 of 3 : UCIP_FA_2020_33114_59898.jpg

LM Start	0.53	Rating **	A/W	Issue No.	11
LM End	0.53	Issue Type +	Ma	Location *	
Category	Supplemental			GPS Latitude/Longitude	
				Start	End
Item	DWR UCIP LMA Responsibility			37.959117 °	37.959117 °
				-121.157567 °	-121.157567 °
DWR ID	18539				
Comment Code					
Inspector Comment					
DS_ID:18539					
FS_ID:33114					
EP_NO: N/A					
Repair Type: No Action Needed					
EVAL Issue:					
Crossing Status: Found					
UCIP Comments: May need cleaning the pipe.					
FIELD_STRUCT_DESC: 30-inch corrugated metal drainage pipe through the levee, 6 feet below the crown. Concrete U-shaped headwalls on both ends. Flap gate on the waterside (WS) end. Grouted inlet and outlet. [Additional Reference(s): DWR Levee Log, 1992, 36-inch pipe listed. USACE San Joaquin O&M Manual 611.1, Volume F, (HLM 0.54)].					
FS Date: 4/4/2014

WS view: CM pipe, flapgate, and concrete headwall on levee slope.

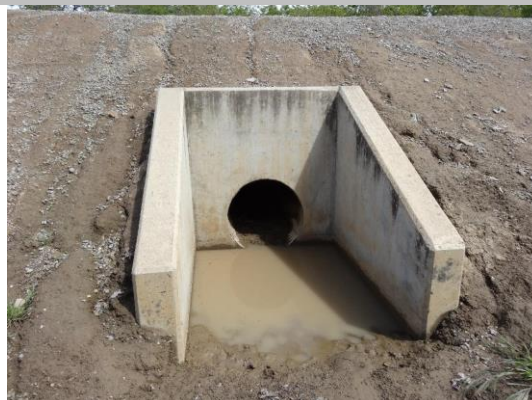
Photo 2 of 3 : UCIP_FA_2020_33114_59897.jpg

LS view: CM pipe, inlet box, and concrete headwall on levee slope.
