**Flood Control Project Maintenance
Levee Inspections**

Maintenance Issue Types Only, Levee Inspection Report By Mile - Fall 2021

San Joaquin County Flood Control and Water Conservation District

Waterway	Bank	Unit Miles	Inspection Start/End	Inspector
Unit No. 01 Littlejohn Creek	Left	2.59	10/21/2021 10/21/2021	Alberto De Leon

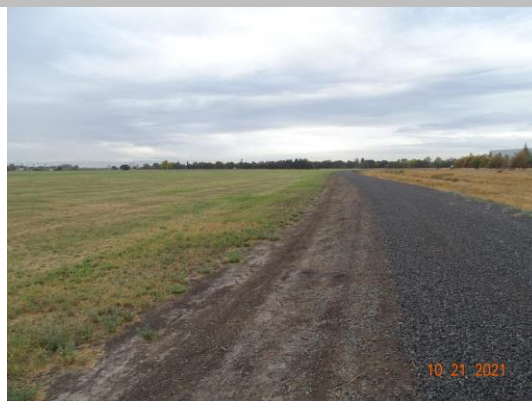
Photo 1 of 1 : FA_2021_NA0017_148_24_20211021_00057.jpg

LM Start	0.00	Rating **	A	Issue No.	24
LM End	2.56	Issue Type +	Ma	Location *	LS
Category	Earthen Levee			GPS Latitude/Longitude	
				Start	End
Item	Vegetation			37.873385 °	37.888038 °
				-121.230940 °	-121.267189 °
DWR ID	DWR_NA0017_01_f_2021_24				
Comment Code					
V1 : Control annual grass and weeds on the levee slopes and easements.					
Inspector Comment

Typical view of well maintained vegetation on the landside slope. Fall 2021

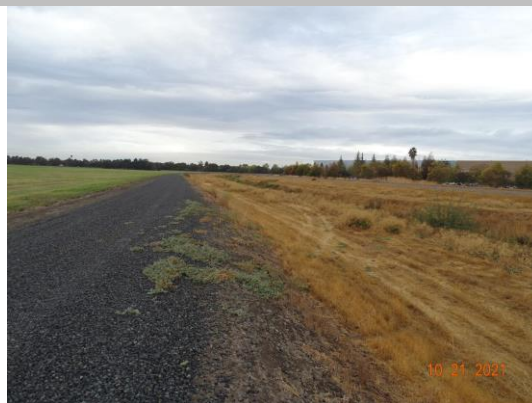
Photo 1 of 1 : FA_2021_NA0017_148_25_20211021_00058.jpg

LM Start	0.00	Rating **	A	Issue No.	25
LM End	2.56	Issue Type +	Ma	Location *	WS
Category	Earthen Levee			GPS Latitude/Longitude	
				Start	End
Item	Vegetation			37.873385 °	37.888038 °
				-121.230940 °	-121.267189 °
DWR ID	DWR_NA0017_01_f_2021_25				
Comment Code					
V1 : Control annual grass and weeds on the levee slopes and easements.					
Inspector Comment

Typical view of well maintained vegetation on waterside slope. Fall 2021

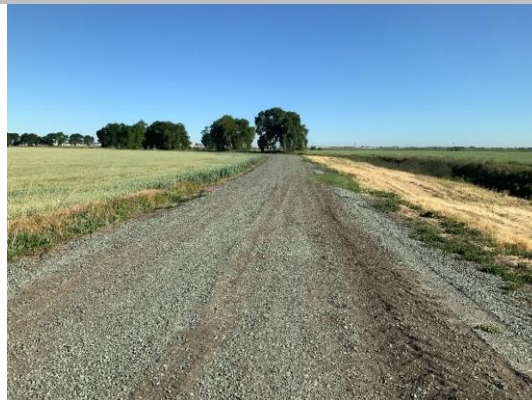
Photo 1 of 3 : UCIP_FA_2021_66995_96776.jpg

Comment Code						
Inspector Comment						
DS_ID:23992 FS_ID:66995 EP_NO: N/A Repair Type: Non-Urgent EVAL Issue: Limited Inspection/No UCIP Evaluation Crossing Status: Found UCIP Comments: 04/27/2021 The record has been upgraded from No Action Needed to Non-Urgent. Water filtration plant and tanks no longer present on LS. Heavy vegetation covering WS pipe over bridge, recommend cleaning around pipe. Levee prism in this section appears to be less than 3 feet. No permit was found authorizing this encroachment. CVFPB will need to review crossing to determine owner. The UCIP inspection was completed with LMA representative, J. Nelson. (H. Dunn – GEI) 03/25/2014 One 4-inch pvc pipe on the waterside levee slope. It is not clear whether the pvc pipe goes through the levee. One air vent on waterside and another across the channel. Water filter plant on landside. (P. Tariq - DWR UCIP)Not found : 24-inch CMP through levee and with flap gate. On landside a vertical pump on wooden structure; walkway to the pump; service pole and switch box. Pump is connected to 8-inch steel pipe for about 100 ft. 24-inch CMP continues through the levee. FIELD_STRUCT_DESC: 8-inch steel storm drainage pipe through the levee, 2 feet below the crown. Pipe goes over the top of the channel on a wood structure. One air vent on the waterside (WS) and another across the channel. Water filter plant on the landside (LS). [Additional Reference(s): DWR Levee Log, 1977, listed as a 14-inch pipe. USACE San Joaquin O&M Manual 613C, Volume 15, May 1963, (Station 131+25 ""S""), listed as a 24-inch corrugated metal pipe (CMP) with a flap gate]. FS Date: 4/27/2021

Levee crown looking downstream.

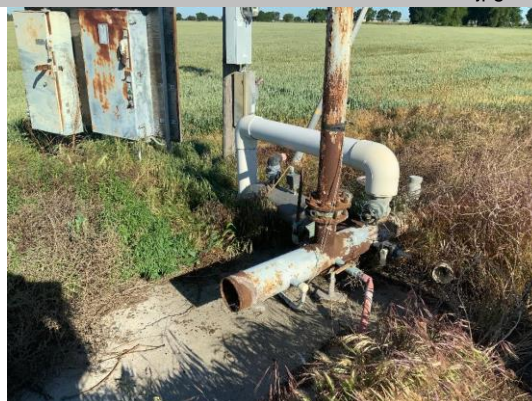
Photo 2 of 3 : UCIP_FA_2021_66995_96781.jpg

LS view: Structure off toe.

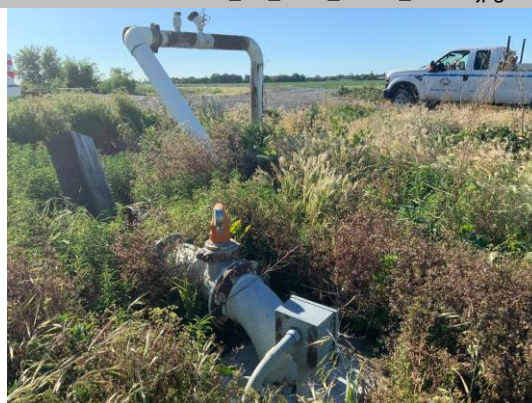
Photo 3 of 3 : UCIP_FA_2021_66995_96775.jpg

LS view: Structure and air valve off toe.

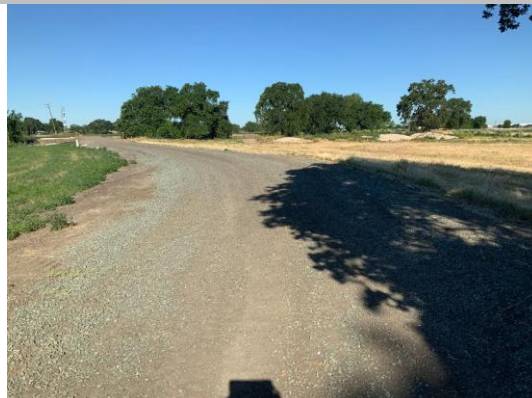
Photo 1 of 3 : UCIP_FA_2021_66998_96798.jpg

DS_ID:17973
FS_ID:66998
EP_NO: N/A
Repair Type: Urgent
EVAL Issue: Flood Risk
Crossing Status: Found
UCIP Comments: 04/27/2021 Pipe status is still Urgent. Slidegate no longer on WS, pipe is open on both ends. LS pipe edges are bent and warped. DWR DMP internal video inspection has found pipe integrity issues. LOF of crossing is between 4.1 and 5. Crossing will be monitored until funding becomes available for rehabilitation. Levee prism in this section appears to be less than 3 feet. No permit was found authorizing this encroachment. CVFPB will need to review crossing to determine owner. The UCIP inspection was completed with LMA representative, J. Nelson. (H. Dunn – GEI) 11/02/2018 Inlet deformed. Outlet missing a slide gate. The LMA states that a new slide gate will be installed in about two weeks. Inlet and outlet have dirt and vegetation issues. Crossing remains "Urgent" until a new slide gate is installed. Contact the LMA to see if they have photographic evidence that a new slide gate was put in. (A. McDonald - DWR UCIP)10/18/2018 Inlet deformed. Outlet missing a slide gate. This means that the pipe cannot be closed during high water. I have escalated this crossing from "No Action Needed" to "Urgent" due to the straight through pipe which could cause flooding during high water. There is a hole in the inlet, due to the deformity. It was most likely ran over by heavy equipment. I do not see enough evidence for an internal pipe inspection. (A. McDonald - DWR UCIP)03/25/2014 May need cleaning of mud in inlet pipe. (W. Wylie - DWR UCIP)

FIELD_STRUCT_DESC: 24-inch corrugated metal drainage culvert through the levee, 4.2 feet below the crown. Slide gate on the waterside (WS) end, not found on 10/18/2018. [Additional Reference(s): DWR Levee Log, 1977. USACE San Joaquin O&M Manual 613C, Volume 15, May 1963, (Station 98+65)].
FS Date: 4/27/2021

Levee crown looking downstream.

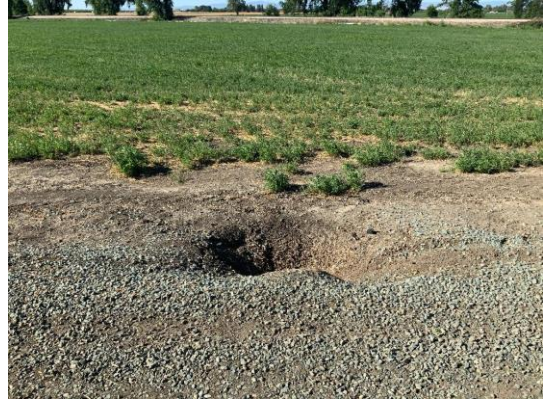
Photo 2 of 3 : UCIP_FA_2021_66998_96792.jpg

LS view: Slope from crown, inlet visible at toe.

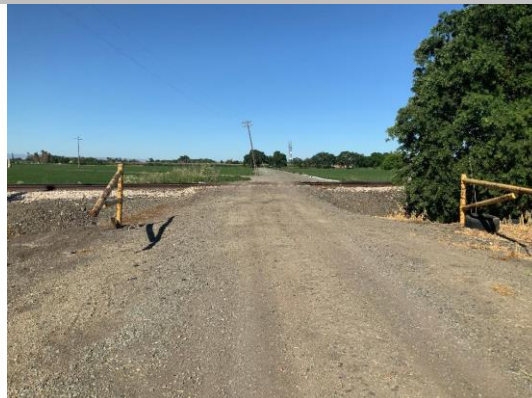
Photo 1 of 3 : UCIP_FA_2021_67003_96806.jpg

Comment Code					
Inspector Comment					
DS_ID:17972 FS_ID:67003 EP_NO: N/A Repair Type: Non-Urgent EVAL Issue: Maintenance Compliance Issue Crossing Status: Found UCIP Comments: 04/27/2021 The record has been upgraded from No Action Needed to Non-Urgent. Some vegetation in front of WS flapgate, recommend removal. DWR DMP internal video inspection has not found pipe integrity issues. LOF of crossing is less or equal to 4.0. Recommend next video inspection in 5 years. Levee prism in this section appears to be less than 3 feet. No permit was found authorizing this encroachment. CVFPB will need to review crossing to determine owner. The UCIP inspection was completed with LMA representative, J. Nelson. (H. Dunn – GEI) 11/02/2018 Inlet and outlet cleared of dirt by the LMA. Crossing has been downgraded to "No Action Needed." (A. McDonald - DWR UCIP)03/25/2014 LS vegetation debris and mud on the inlet ditch and inside the pipe. (P. Amaty - DWR UCIP) FIELD_STRUCT_DESC: 1 of 2: 36-inch corrugated metal drainage pipe through the levee, 6.6 feet below the crown. Flap gate on the waterside (WS) end. [Additional Reference(s): DWR Levee Log, 1977. USACE San Joaquin O&M Manual 613C, Volume 15, May 1963 (Station 94+40)]. FS Date: 4/27/2021

Levee crown looking downstream.

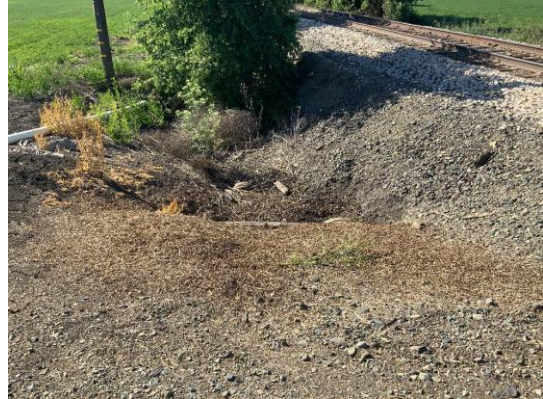
Photo 2 of 3 : UCIP_FA_2021_67004_96815.jpg

LS view: Headwall visible at toe from crown.

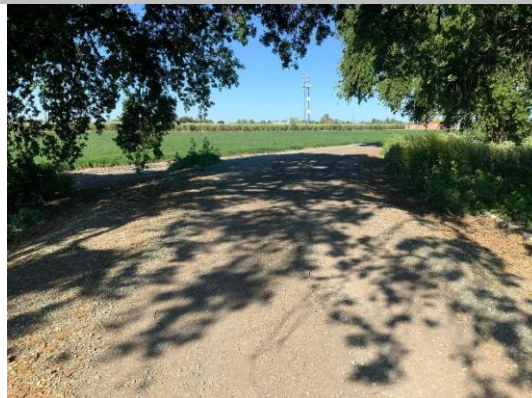
Photo 1 of 3 : UCIP_FA_2021_67008_96822.jpg

Comment Code						
Inspector Comment						
DS_ID:23985 FS_ID:67008 EP_NO: N/A Repair Type: Non-Urgent EVAL Issue: Pipe Damage Crossing Status: Found UCIP Comments: 04/27/2021 The record has been upgraded from No Action Needed to Non-Urgent. DWR DMP internal video inspection has found pipe integrity issues. LOF of crossing is between 4.1 and 5. Crossing will be monitored until funding becomes available for rehabilitation. LS and WS pipe end and flapgate both partially covered by vegetation debris, recommend removal. The levee prism in this section appears to be less than 3 feet. No permit was found authorizing this encroachment. CVFPB will need to review crossing to determine owner. The UCIP inspection was completed with LMA representative, J. Nelson. (H. Dunn – GEI) 11/02/2018 Inlet and outlet cleared of dirt and vegetation by the LMA. Crossing has been downgraded to "No Action Needed." (A. McDonald - DWR UCIP)03/25/2014 Debris and mud on inlet ditch and inside pipe. Needs cleaning and clearing the culvert. (P. Amatya - DWR UCIP) FIELD_STRUCT_DESC: 30-inch corrugated metal drainage pipe through the levee, 11 feet below the crown. Flap gate on the waterside (WS). [Additional Reference(s): USACE San Joaquin O&M Manual 613C, Volume 15, May 1963, (Station 83+00)]. FS Date: 4/27/2021

Levee crown looking downstream.

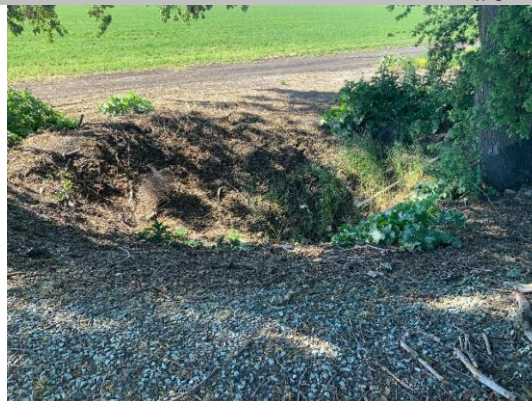
Photo 2 of 3 : UCIP_FA_2021_67008_96823.jpg

LS view: Toe from crown.

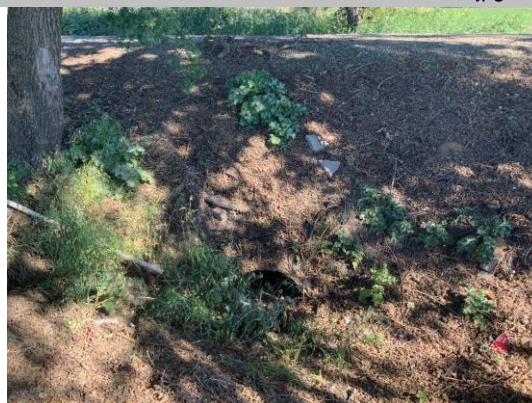
Photo 3 of 3 : UCIP_FA_2021_67008_96824.jpg

LS view: Pipe inlet at toe.

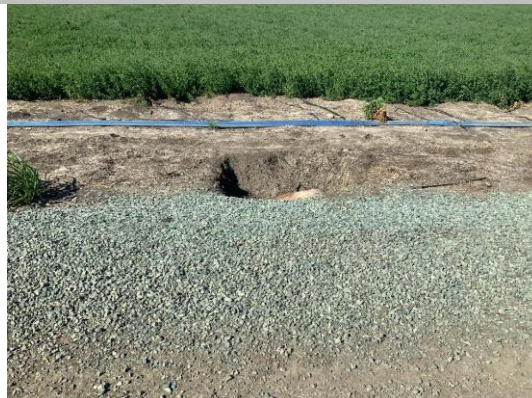
Photo 2 of 3 : UCIP_FA_2021_65263_96830.jpg

DS_ID:17970
 FS_ID:65263
 EP_NO: N/A
 Repair Type: Urgent
 EVAL Issue: Pipe Integrity
 Crossing Status: Found
 UCIP Comments: 04/27/2021 The record has been upgraded from Non-Urgent to Urgent. DWR DMP internal video inspection has found pipe integrity issues. LOF of crossing is between 5 and 6. Crossing will be monitored until funding becomes available to address the issues. The levee prism in this section appears to be less than 3 feet. No permit was found authorizing this encroachment. CVFPB will need to review crossing to determine owner. The UCIP inspection was completed with LMA representative, J. Nelson. (H. Dunn – GEI)11/02/2018 Inlet still deformed. Inlet and outlet cleared of dirt and vegetation by the LMA. Crossing continues to be rated "Non-Urgent." (A. McDonald - DWR UCIP)03/25/2014 Needs cleaning and clearing the culvert. (P. Amaty - DWR UCIP)
 FIELD_STRUCT_DESC: 24-inch corrugated metal drainage pipe through the levee, 4.1 feet below the crown. Flap gate on the waterside (WS) end. [Additional Reference(s): DWR Levee Log, 1977. USACE San Joaquin O&M Manual 613C, Volume 15, May 1963, (Station 76+60)].

LS view: Toe from crown.

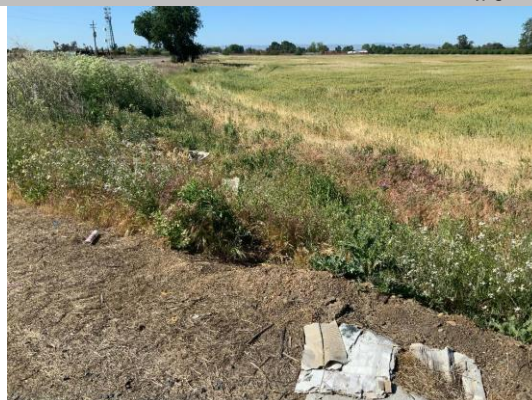
Photo 2 of 3 : UCIP_FA_2021_67070_96842.jpg

Comment Code						
Inspector Comment						
DS_ID:17969 FS_ID:67070 EP_NO: N/A Repair Type: Non-Urgent EVAL Issue: Unauthorized Modification or Non-Compliant Permit Crossing Status: Found UCIP Comments: 04/27/2021 Pipe status is still Non-Urgent. This pipe appears abandoned, no standpipe on WS and no inlet structure on LS. Only pipe with appurtenance left on WS. The levee prism in this section appears to be less than 3 feet. No permit was found authorizing this encroachment. CVFPB will need to review crossing to determine owner. The UCIP inspection was completed with LMA representative, J. Nelson. (H. Dunn – GEI) 03/25/2014 Appears abandoned and should be verified as having been done so properly. (P. Tariq - DWR UCIP)Concrete standpipe on waterside. Abandoned gate valve on waterside. Steel pipe disconnected with the standpipe.Inlet structure with steel gates and 18-inch alfalfa valve on landside. FIELD_STRUCT_DESC: 18-inch reinforced concrete drainage pipe through the levee, 6.2 feet below the crown. [Additional Reference(s): DWR Levee Log, 1977. USACE San Joaquin O&M Manual 613C, Volume 15, May 1963, (Station 68+90) 21-inch pipe listed]. FS Date: 4/27/2021

LS view: Slope from crown, no inlet structure seen.

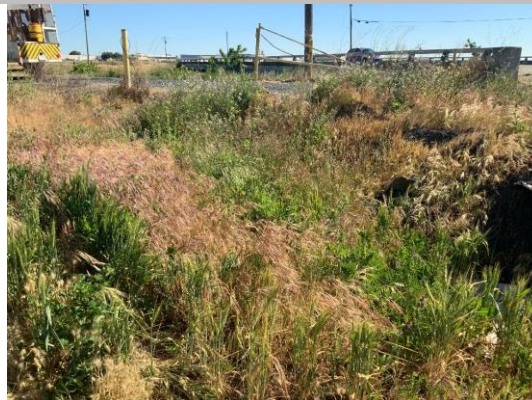
Photo 3 of 3 : UCIP_FA_2021_67070_96843.jpg

LS view: Slope from toe, no inlet structure seen.

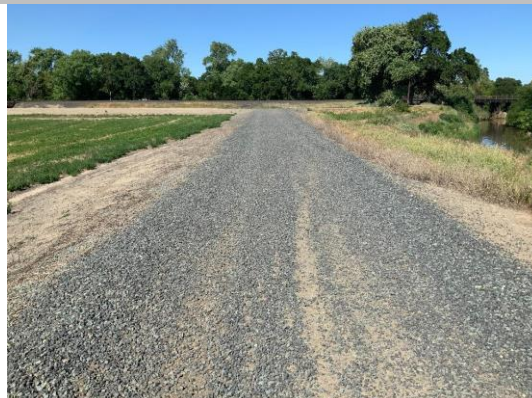
Photo 1 of 3 : UCIP_FA_2021_67084_96871.jpg

Comment Code						
Inspector Comment						
DS_ID:17966 FS_ID:67084 EP_NO: N/A Repair Type: Non-Urgent EVAL Issue: Limited Inspection/No UCIP Evaluation Crossing Status: Found UCIP Comments: 04/27/2021 The record has been upgraded from No Action Needed to Non-Urgent. WS flapgate completely covered in vegetation and LS inlet has some sediment buildup inside, recommend cleaning on both ends. DWR DMP internal video inspection has not found pipe integrity issues. LOF of crossing is less or equal to 4.0. Recommend next video inspection in 5 years No permit was found authorizing this encroachment. CVFPB will need to review crossing to determine owner. The levee prism in this section appears to be less than 3 feet. The UCIP inspection was completed with LMA representative, J. Nelson. (H. Dunn – GEI) 11/02/2018 Inlet uncovered from the dirt by the LMA. Some vegetation at the flap gate. Crossing continues to be rated "No Action Needed." (A. McDonald - DWR UCIP)03/25/2014 Grouted riprap outlet box and concrete outfall pipe on waterside. Pipe not visible on landside. (P. Amatya - DWR UCIP) FIELD_STRUCT_DESC: 24-inch corrugated metal drainage pipe through the levee, 5 feet below the crown. Flap gate on the waterside (WS) end. Grouted riprap outlet box and concrete outfall pipe on the WS. [Additional Reference(s): DWR Levee Log, 1977. USACE San Joaquin O&M Manual 613C, Volume 15, May 1963, (Station 4+00)]. FS Date: 4/27/2021

Levee crown looking downstream.

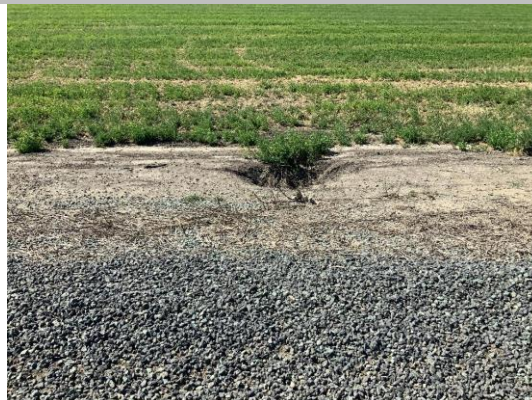
Photo 2 of 3 : UCIP_FA_2021_67084_96872.jpg

LS view: Slope from crown.

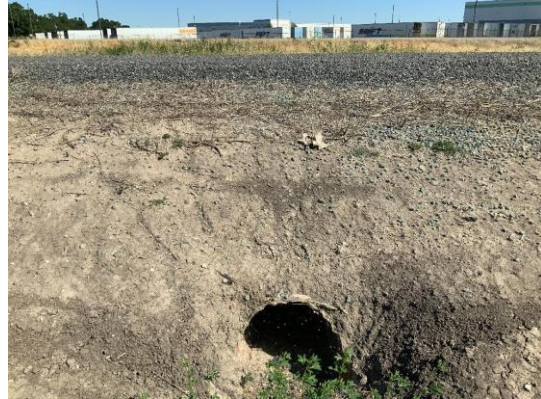
Photo 3 of 3 : UCIP_FA_2021_67084_96873.jpg

LS view: Pipe inlet at toe.

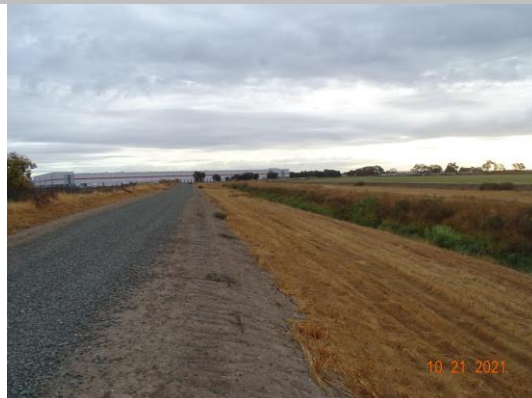
Photo 1 of 1 : FA_2021_NA0017_149_34_20211021_00089.jpg

LM Start	0.00	Rating **	A	Issue No.	34
LM End	3.15	Issue Type +	Ma	Location *	WS
Category	Earthen Levee			GPS Latitude/Longitude	
				Start	End
Item	Vegetation			37.875123 °	37.888513 °
				-121.220054 °	-121.267290 °
DWR ID	DWR_NA0017_02_f_2021_34				
Comment Code					
V1 : Control annual grass and weeds on the levee slopes and easements.					
Inspector Comment

Typical view of well maintained vegetation on waterside slope. Fall 2021

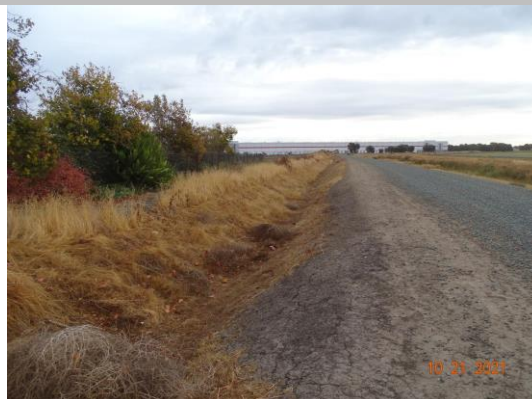
Photo 1 of 1 : FA_2021_NA0017_149_33_20211021_00088.jpg

LM Start	0.00	Rating **	A	Issue No.	33
LM End	3.15	Issue Type +	Ma	Location *	LS
Category	Earthen Levee			GPS Latitude/Longitude	
				Start	End
Item	Vegetation			37.875122 °	37.888513 °
				-121.220055 °	-121.267290 °
DWR ID	DWR_NA0017_02_f_2021_33				
Comment Code					
V1 : Control annual grass and weeds on the levee slopes and easements.					
Inspector Comment

Typical view of well maintained vegetation on the landside slope. Fall 2021

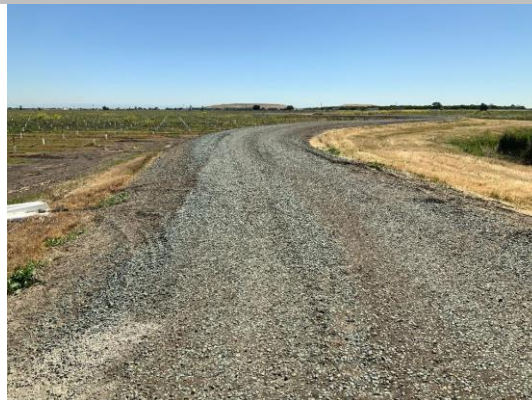
Photo 1 of 3 : UCIP_FA_2021_67106_96992.jpg

Comment Code						
Inspector Comment						
DS_ID:17986 FS_ID:67106 EP_NO: N/A Repair Type: Urgent EVAL Issue: Flood Risk Crossing Status: Found UCIP Comments: 04/28/2021 The record has been upgraded from No Action Needed to Urgent. No flapgate on the WS, pipe is open on both ends. There is an 8inch plastic pipe now going through this metal pipe that looks to go underground possibly under the channel on WS. Need more information from owner. No permit was found authorizing this encroachment. CVFPB will need to review crossing to determine owner. The UCIP inspection was completed with LMA representative, J. Nelson. (H. Dunn – GEI) 11/02/2018 Inlet cleared of dirt and vegetation by the LMA. Crossing continues to be rated "No Action Needed." (A. McDonald - DWR UCIP)04/02/2014 May need cleaning. (P. Amatya - DWR UCIP) FIELD_STRUCT_DESC: 24-inch corrugated metal drainage pipe through the levee, 5 feet below the crown. Flap gate on the waterside (WS) end. [Additional Reference(s): DWR Levee Log, 1977. USACE San Joaquin O&M Manual 613C, Volume 15, May 1963, (Station 148+18N)]. FS Date: 4/28/2021

Levee crown looking upstream.

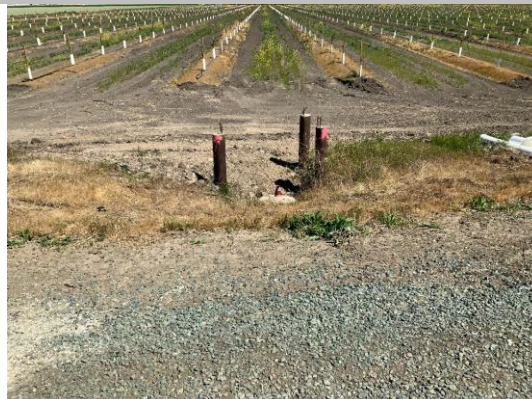
Photo 2 of 3 : UCIP_FA_2021_67106_96994.jpg

LS view: Pipe end visible at toe from crown.

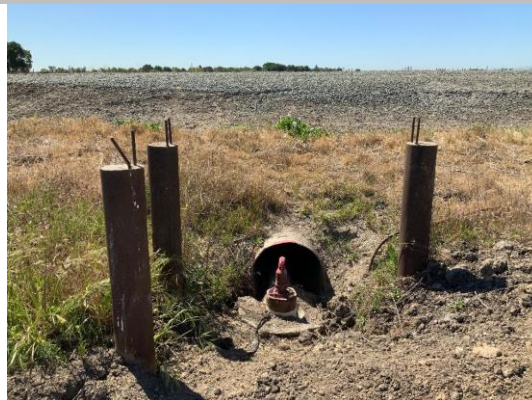
Photo 3 of 3 : UCIP_FA_2021_67106_96995.jpg

LS view: Pipe inlet at toe.

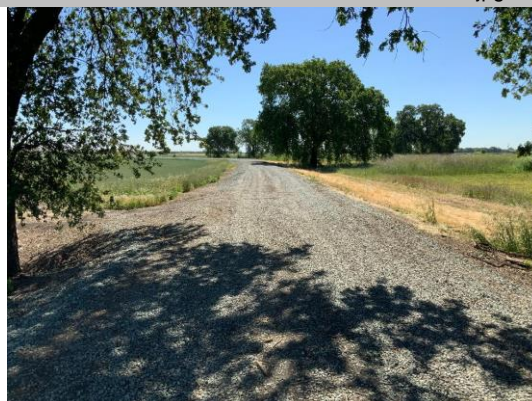
Photo 1 of 3 : UCIP_FA_2021_67104_97012.jpg

Comment Code						
Inspector Comment						
DS_ID:17983 FS_ID:67104 EP_NO: N/A Repair Type: Non-Urgent EVAL Issue: Unauthorized Encroachment, installed decades prior Crossing Status: Found UCIP Comments: 04/28/2021 The record has been upgraded from No Action Needed to Non-Urgent. No permit was found authorizing this encroachment. CVFPB will need to review crossing to determine owner. The UCIP inspection was completed with LMA representative, J. Nelson. (H. Dunn – GEI) 11/02/2018 Inlet and outlet cleared of dirt and vegetation by the LMA. Crossing has been downgraded to "No Action Needed." (A. McDonald - DWR UCIP)04/02/2014 Needs cleaning and clearing the culvert. (P. Amatya - DWR UCIP) FIELD_STRUCT_DESC: 24-inch corrugated metal drainage pipe through the levee, 6.4 feet below the crown. Flap gate on the waterside (WS) end. [Additional Reference(s): DWR Levee Log, 1977. USACE San Joaquin O&M Manual 613C, Volume 15, May 1963, (Station 114+50)]. FS Date: 4/28/2021

Levee crown looking upstream.

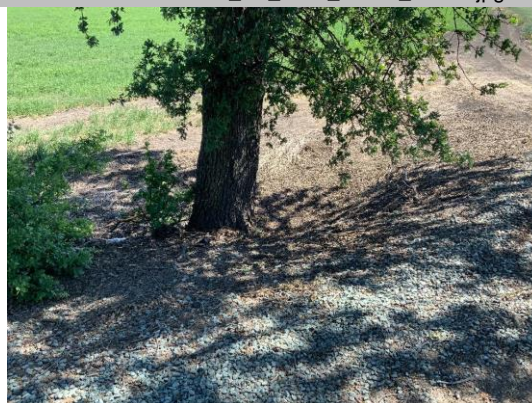
Photo 2 of 3 : UCIP_FA_2021_67104_97013.jpg

LS view: Slope and toe from crown.

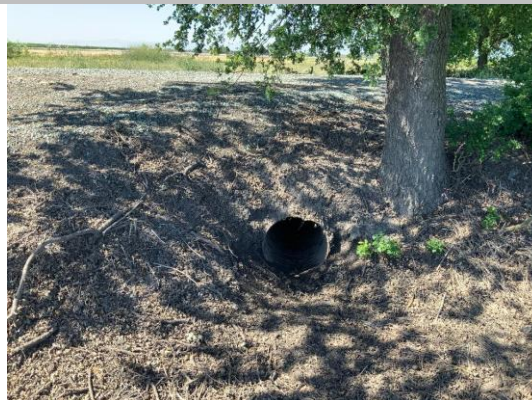
Photo 3 of 3 : UCIP_FA_2021_67104_97014.jpg

LS view: Slope and pipe inlet at toe.

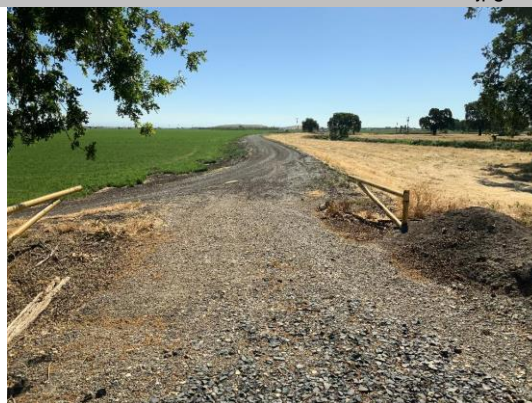
Photo 1 of 3 : UCIP_FA_2021_67093_97051.jpg

Comment Code					
Inspector Comment					
DS_ID:23984 FS_ID:67093 EP_NO: N/A Repair Type: Non-Urgent EVAL Issue: Unauthorized Encroachment, installed decades prior Crossing Status: Found UCIP Comments: 04/28/2021 Record has been upgraded from No Action Needed to Non-Urgent. Unit 2 – Littlejohn Creek (CLM 1.20 to 1.70) is considered a patrol road/high ground area with no defined levee prism, any issue found between CLM 1.20-1.70 of Unit 2 will be considered a maintenance issue, or an unauthorized encroachment, or an abandoned encroachment. DWR DMP internal video inspection has not found pipe integrity issues. LOF of crossing is less or equal to 4.0. Recommend next video inspection in 5 years. Minor warping of LS pipe edges. Current condition of pipe crossing does not impede access to patrol road/high ground area. No permit was found authorizing this encroachment. CVFPB will need to review crossing to determine owner. The UCIP inspection was completed with LMA representative, J. Nelson. (H. Dunn – GEI) 11/02/2018 Inlet and outlet cleared of dirt and vegetation by the LMA. Crossing continues to be rated "No Action Needed." (A. McDonald - DWR UCIP)04/02/2014 May need cleaning. (P. Amatya - DWR UCIP) FIELD_STRUCT_DESC: 24-inch corrugated metal drainage pipe with flap gate through the levee, at an unknown depth. [Additional Reference(s): USACE San Joaquin O&M Manual 613C, Volume 15, May 1963, (Station 93+00)]. FS Date: 4/28/2021

Levee crown looking upstream.

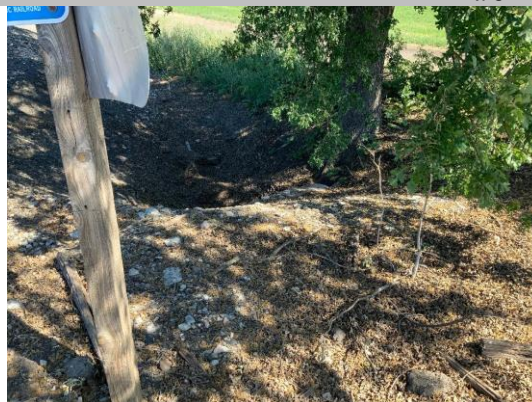
Photo 2 of 3 : UCIP_FA_2021_67093_97052.jpg

LS view: Toe from crown.

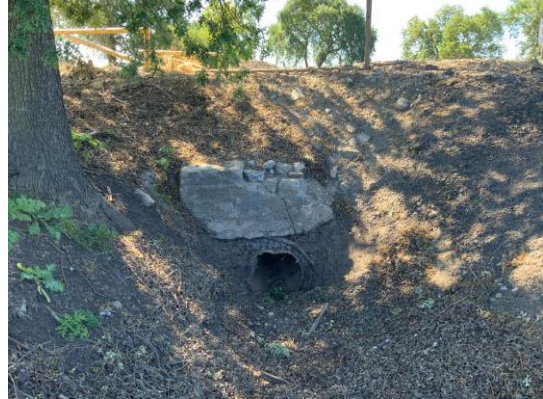
Photo 3 of 3 : UCIP_FA_2021_67093_97053.jpg

LS view: Slope and pipe inlet at toe.

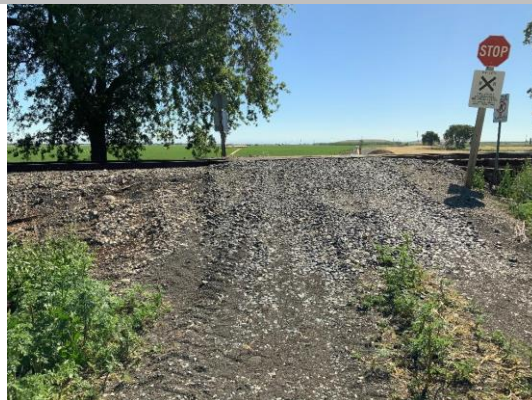
Photo 1 of 3 : UCIP_FA_2021_67094_97062.jpg

Comment Code					
Inspector Comment					
DS_ID:23998 FS_ID:67094 EP_NO: N/A Repair Type: Non-Urgent EVAL Issue: Maintenance Compliance Issue Crossing Status: Found UCIP Comments: 04/28/2021 Record has been upgraded from No access to patrol road/high ground area. No permit was found Action Needed to Non-Urgent. Unit 2 – Littlejohn Creek (CLM 1.20 to 1.70) is considered a patrol road/high ground area with no defined levee prism, any issue found between CLM 1.20-1.70 of Unit 2 will be considered a maintenance issue, or an unauthorized encroachment, or an abandoned encroachment. DWR DMP internal video inspection has found pipe integrity issues. LOF of crossing is between 4.1 and 5. Crossing will be monitored until funding becomes available for rehabilitation. Current condition of pipe crossing does not impede access to patrol road/high ground area. No permit was found authorizing this encroachment. CVFPB will need to review crossing to determine owner. The UCIP inspection was completed with LMA representative, J. Nelson. (H. Dunn – GEI) 11/02/2018 Inlet and outlet cleared of dirt and vegetation by the LMA. This crossing continues to be rated "No Action Needed." (A. McDonald - DWR UCIP)04/02/2014 Galvanized iron plate slide gate on waterside. It is not not a old pipe. The plate gate looks new. (P. Amatya - DWR UCIP) FIELD_STRUCT_DESC: 16-inch high-density polyethylene drainage pipe through the levee, 7.7 feet below the crown. Galvanized iron plate gate on the waterside (WS) end. [Additional Reference(s): USACE San Joaquin O&M Manual 613C, Volume 15, May 1963, (Station 91+80) 12- inch steel pipe listed]. FS Date: 4/28/2021

Levee crown looking upstream.

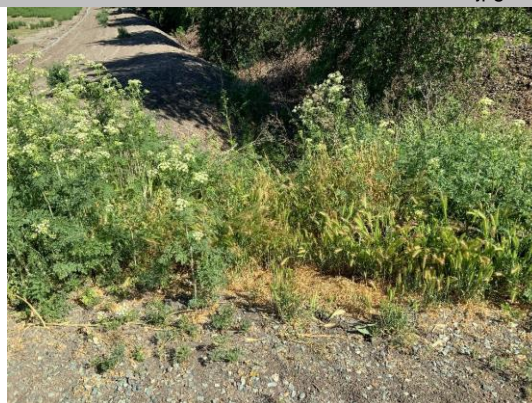
Photo 2 of 3 : UCIP_FA_2021_67094_97066.jpg

LS view: Toe from crown.

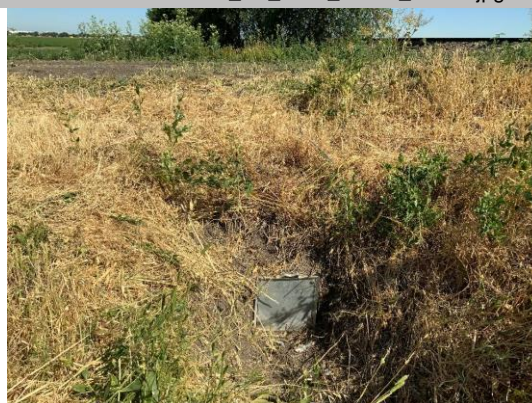
Photo 3 of 3 : UCIP_FA_2021_67094_97063.jpg

WS view: Slope and plate gate at toe.

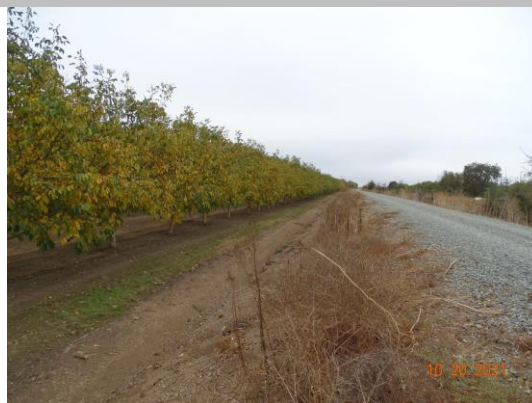
Photo 1 of 1 : FA_2021_NA0017_150_5_20211020_00010.jpg

LM Start	0.41	Rating **	M	Issue No.	5
LM End	0.46	Issue Type +	Ma	Location *	LS
Category	Earthen Levee			GPS Latitude/Longitude	
				Start	End
Item	Vegetation			37.979280 °	37.979310 °
				-121.091427 °	-121.090437 °
DWR ID	DWR_NA0017_06_f_2021_5				
Comment Code					
V1 : Control annual grass and weeds on the levee slopes and easements.					
Inspector Comment

Typical view of vegetation along the landside slope. Fall 2021

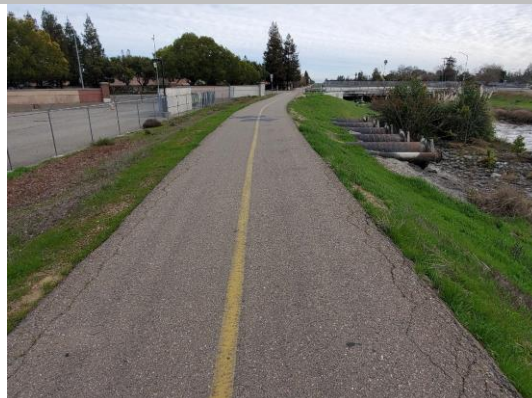
Photo 1 of 3 : UCIP_FA_2021_66385_95727.jpg

Comment Code						
Inspector Comment						
DS_ID:23695 FS_ID:66385 EP_NO: N/A Repair Type: Non-Urgent EVAL Issue: Unauthorized Encroachment, installed decades prior Crossing Status: Found UCIP Comments: 02/16/2021 The record has been upgraded from No Action Needed to Non-Urgent. No permit was found authorizing this encroachment. CVFPB will need to review crossing to determine owner. The UCIP inspection was completed with GEI staff, H. Dunn and LMA representative, M. Mccoy. (B. Singh – GEI) FIELD_STRUCT_DESC: [Thornton Road Pump Station] 1 of 6: 12-inch wrapped steel storm drainage pipe through the levee, approximately 3 feet below the crown. Pump station on the landside (LS). Flap gate on the waterside (WS) end. [Additional Reference(s): USACE San Joaquin O&M Manual 612 (addendum), February 1999, (HLM 2.16) (Station 114+25)]. FS Date: 2/16/2021

Overview of levee crown, looking US

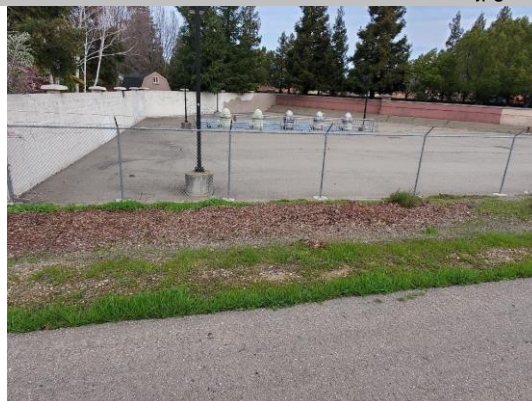
Photo 2 of 3 : UCIP_FA_2021_66385_95728.jpg

LS view: View toward LS toe and pumping plant from levee crown

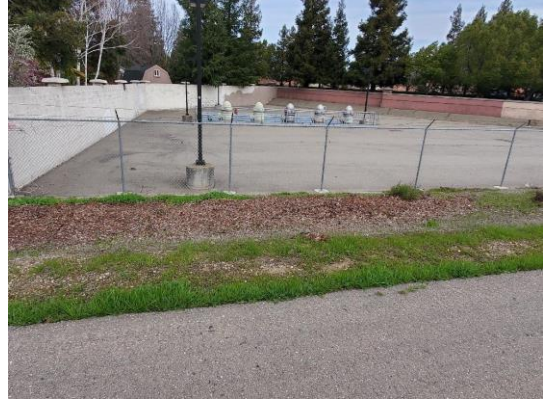
Photo 2 of 3 : UCIP_FA_2021_66387_95734.jpg

LS view: View toward LS toe and pump station from levee crown

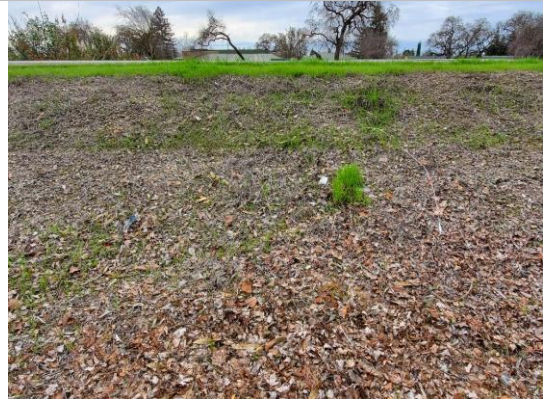
Photo 3 of 3 : UCIP_FA_2021_66387_95735.jpg

LS view: LS slope from LS toe

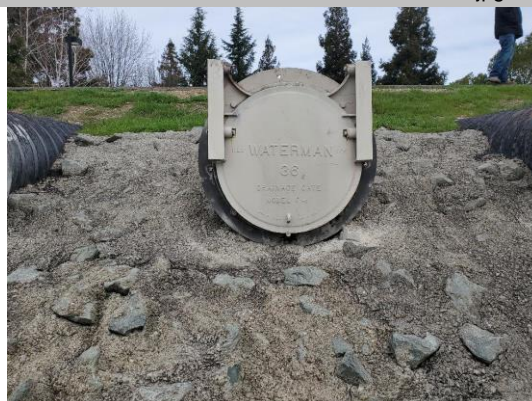
Photo 1 of 3 : UCIP_FA_2021_66388_95739.jpg

Comment Code					
Inspector Comment					
DS_ID:23691 FS_ID:66388 EP_NO: N/A Repair Type: Non-Urgent EVAL Issue: Unauthorized Encroachment, installed decades prior Crossing Status: Found UCIP Comments: 02/16/2021 The record has been upgraded from No Action Needed to Non-Urgent. No permit was found authorizing this encroachment. CVFPB will need to review crossing to determine owner. The UCIP inspection was completed with GEI staff, H. Dunn and LMA representative, M. Mccoy. (B. Singh – GEI) FIELD_STRUCT_DESC: [Thornton Road Pump Station] 3 of 6: 36-inch wrapped steel storm drainage pipe through the levee, approximately 3 feet below the crown. Pump station on the landside (LS). Flap gate on the waterside (WS) end. [Additional Reference(s): USACE San Joaquin O&M Manual 612 (addendum), February 1999, (HLM 2.16) (Station 114+25)]. FS Date: 2/16/2021

WS view: Pipe at WS toe

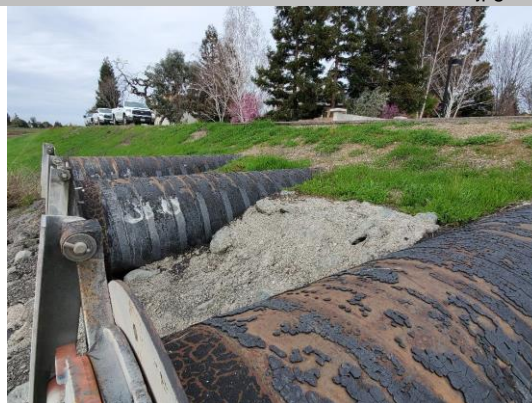
Photo 2 of 3 : UCIP_FA_2021_66388_95740.jpg

WS view: Pipe and WS slope from WS toe

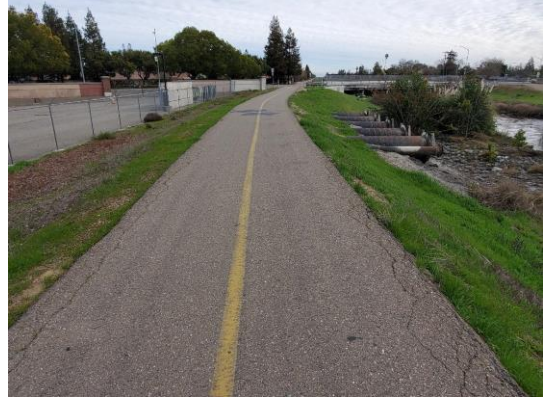
Photo 2 of 3 : UCIP_FA_2021_66389_95746.jpg

Overview of levee crown, looking US

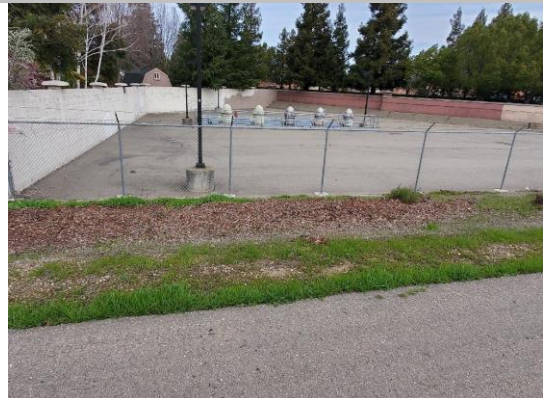
Photo 3 of 3 : UCIP_FA_2021_66389_95747.jpg

LS view: View toward LS toe and pump station from levee crown

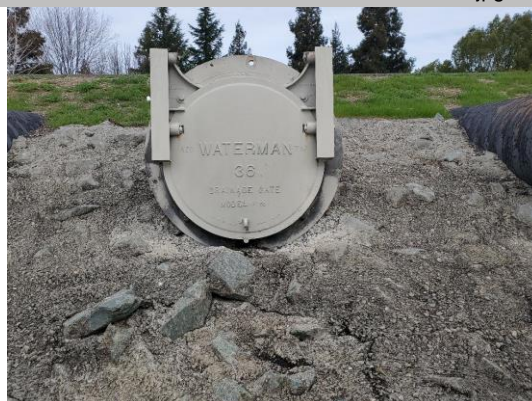
Photo 1 of 3 : UCIP_FA_2021_66390_95749.jpg

Comment Code						
Inspector Comment						
DS_ID:23693 FS_ID:66390 EP_NO: N/A Repair Type: Non-Urgent EVAL Issue: Unauthorized Encroachment, installed decades prior Crossing Status: Found UCIP Comments: 02/16/2021 The record has been upgraded from No Action Needed to Non-Urgent. No permit was found authorizing this encroachment. CVFPB will need to review crossing to determine owner. The UCIP inspection was completed with GEI staff, H. Dunn and LMA representative, M. Mccoy. (B. Singh – GEI) FIELD_STRUCT_DESC: [Thornton Road Pump Station] 5 of 6: 36-inch wrapped steel storm drainage pipe through the levee, approximately 3 feet below the crown. Pump station on the landside (LS). Flap gate on the waterside (WS) end. [Additional Reference(s): USACE San Joaquin O&M Manual 612 (addendum), February 1999, (HLM 2.16) (Station 114+25)]. FS Date: 2/16/2021

WS view: Pipe at WS toe

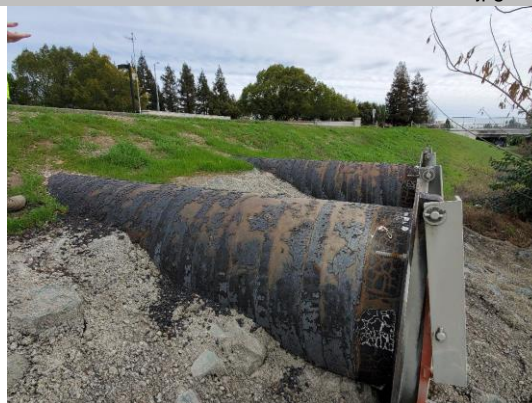
Photo 2 of 3 : UCIP_FA_2021_66390_95750.jpg

WS view: Pipe and slope from WS toe

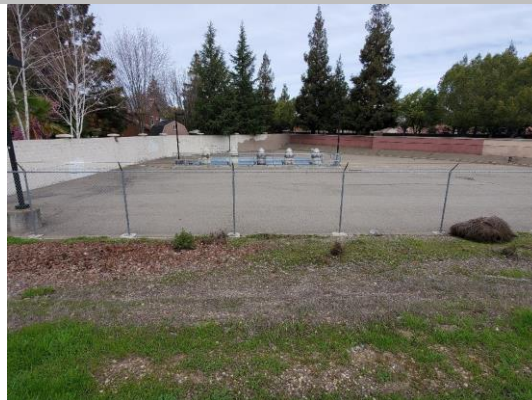
Photo 3 of 3 : UCIP_FA_2021_66390_95751.jpg

LS view: View toward pump station and LS toe from levee crown

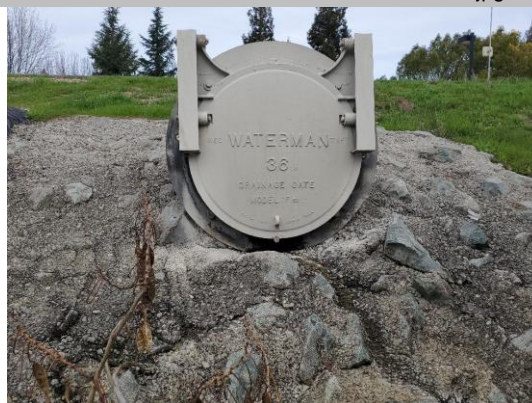
Photo 1 of 3 : UCIP_FA_2021_66391_95755.jpg

DS_ID:23694
 FS_ID:66391
 EP_NO: N/A
 Repair Type: Non-Urgent
 EVAL Issue: Unauthorized Encroachment, installed decades prior
 Crossing Status: Found
 UCIP Comments: 02/16/2021 The record has been upgraded from No Action Needed to Non-Urgent. No permit was found authorizing this encroachment. CVFPB will need to review crossing to determine owner. The UCIP inspection was completed with GEI staff, H. Dunn and LMA representative, M. McCoy. (B. Singh – GEI)
 FIELD_STRUCT_DESC: [Thornton Road Pump Station] 6 of 6: 36-inch wrapped steel storm drainage pipe through the levee, approximately 3 feet below the crown. Pump station on the landside (LS). Flap gate on the waterside (WS) end. [Additional Reference(s): USACE San Joaquin O&M Manual 612 (addendum), February 1999, (HLM 2.16) (Station 114+25)].
 FS Date: 2/16/2021

WS view: Pipe at WS toe

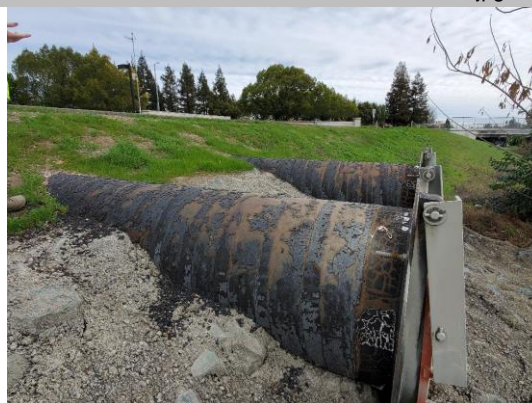
Photo 2 of 3 : UCIP_FA_2021_66391_95756.jpg

WS view: Pipe (right) and WS slope from WS toe

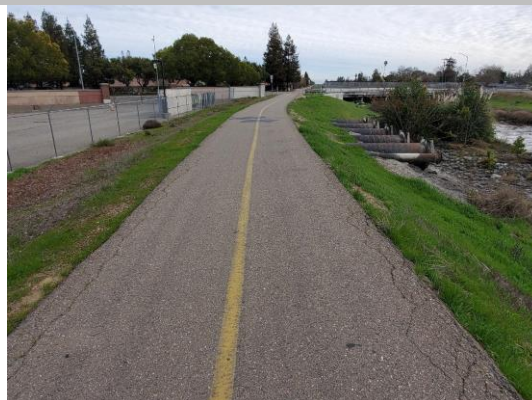
Photo 3 of 3 : UCIP_FA_2021_66391_95757.jpg

Overview of levee crown, looking US

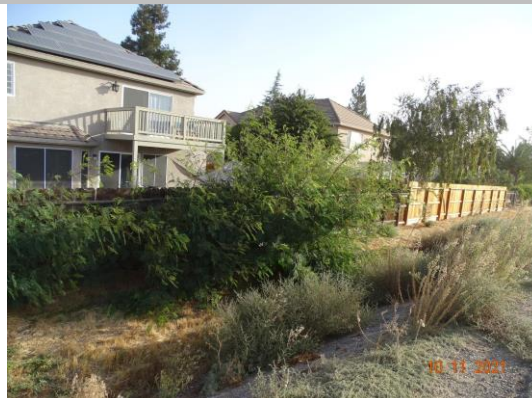
Photo 1 of 1 : FA_2021_NA0017_151_253_20211018_00568.jpg

LM Start	2.13	Rating **	M	Issue No.	253
LM End	2.13	Issue Type +	Ma	Location *	LS
Category	Earthen Levee			GPS Latitude/Longitude	
				Start	End
Item	Trim / Thin Trees			38.043225 °	38.043225 °
				-121.334541 °	-121.334541 °
DWR ID	DWR_NA0017_07_f_2021_253				
Comment Code					
T2 : Thin trees to allow visibility of the ground and room to flood fight.					
Inspector Comment

View of untrimmed tree within the landside easement. Fall 2021

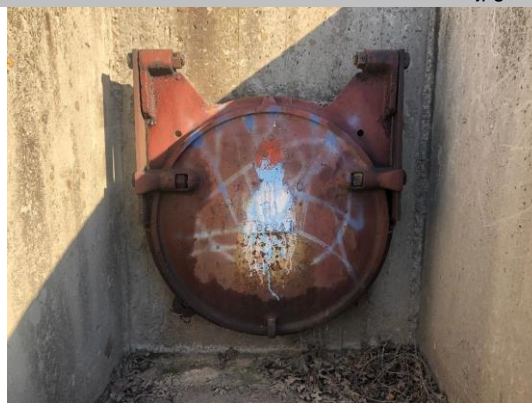
Photo 1 of 3 : UCIP_FA_2021_66461_91080.jpg

Comment Code						
Inspector Comment						
DS_ID:23522 FS_ID:66461 EP_NO: N/A Repair Type: Non-Urgent EVAL Issue: Unauthorized Encroachment, installed decades prior Crossing Status: Found UCIP Comments: 02/17/2021 Record was updated from No Action Needed to Non-Urgent. Upon inspection, LS pipe edges were warped and the coated tar lining deteriorating. DWR DMP internal inspection has not found pipe integrity issues. LOF of crossing is less or equal to 4.0. Recommend next video inspection in 5 years. No permit was found authorizing this encroachment. CVFPB will need to review crossing to determine owner. The UCIP inspection was completed with GEI staff, B. Singh, N. Cholewinski, and LMA representative, J. Caruso. (H. Dunn – GEI) FIELD_STRUCT_DESC: 24-inch corrugated metal drainage pipe through the levee, 5.5 feet below the crown. Concrete U-shaped headwalls on both ends. Flap gate on the waterside (WS) end. Cobble grouted spillway across the berm. [Additional Reference(s): DWR Levee Log, 1987. USACE San Joaquin O&M Manual 612.1, June 1965, (HLM 2.59)]. FS Date: 2/17/2021

WS view: Flapgate on WS toe.

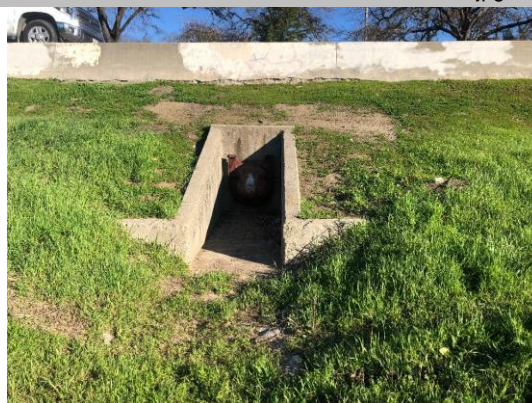
Photo 2 of 3 : UCIP_FA_2021_66461_91081.jpg

WS view: Headwall and flapgate on WS toe.

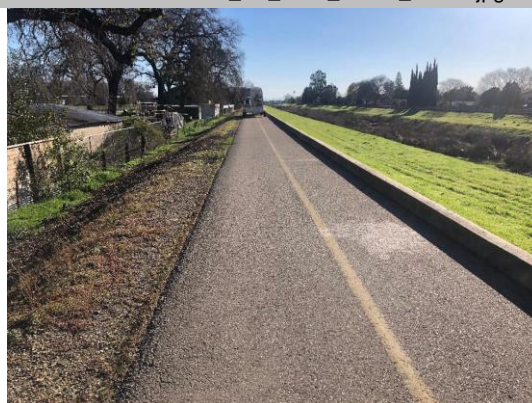
Photo 3 of 3 : UCIP_FA_2021_66461_91082.jpg

Levee crown.

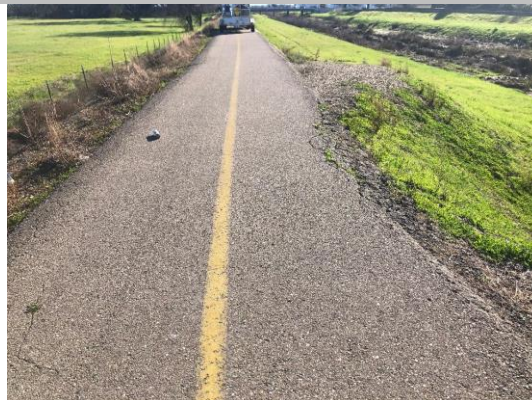
Photo 1 of 3 : UCIP_FA_2021_63990_91085.jpg

Comment Code						
Inspector Comment						
DS_ID:23523 FS_ID:63990 EP_NO: N/A Repair Type: Non-Urgent EVAL Issue: Unauthorized Encroachment, installed decades prior Crossing Status: Found UCIP Comments: 02/17/2021 Record was updated from No Action Needed to Non-Urgent. DWR DMP has not found internal issues, LOF between 1 and 2. Recommend inspection in 5 years. Barbed wire over the LS toe headwall, could not inspect further. No permit was found authorizing this encroachment. CVFPB will need to review crossing to determine owner. The UCIP inspection was completed with GEI staff, B. Singh, N. Cholewinski, and LMA representative, J. Caruso. (H. Dunn – GEI) FIELD_STRUCT_DESC: 24-inch corrugated metal drainage pipe through the levee, 10 feet below the crown. Concrete U-shaped headwalls on both ends. Flap gate on the waterside (WS) end. Cobble grouted spillway across berm. [Additional Reference(s): DWR Levee Log, 1987. USACE San Joaquin O&M Manual 612.1, June 1965, (HLM 2.82)]. FS Date: 2/17/2021

Levee crown.

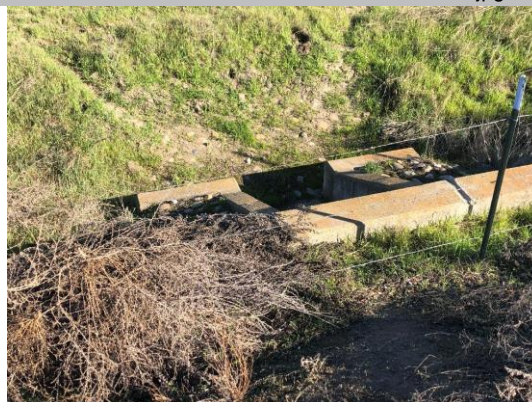
Photo 2 of 3 : UCIP_FA_2021_63990_91086.jpg

LS view: LS headwall from crown. Note barbed wire prevented access to pipe.

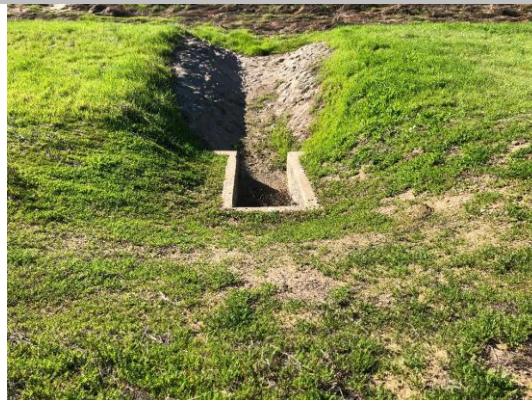
Photo 3 of 3 : UCIP_FA_2021_63990_91087.jpg

LS view: WS headwall at toe from crown.

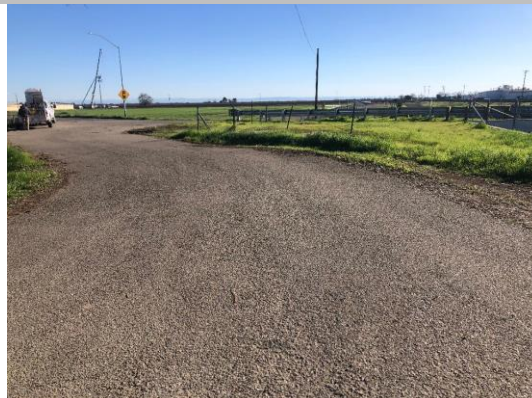
Photo 1 of 3 : UCIP_FA_2021_66466_91140.jpg

Comment Code						
Inspector Comment						
DS_ID:23525 FS_ID:66466 EP_NO: N/A Repair Type: Non-Urgent EVAL Issue: Unauthorized Encroachment, installed decades prior Crossing Status: Found UCIP Comments: 02/17/2021 Record was updated from No Action Needed to Non-Urgent. DWR DMP has not found internal issues, LOF between 1 and 2. Recommend inspection in 5 years. Minor erosion on one edge of the LS headwall. CVFPB will need to review crossing to determine owner. The UCIP inspection was completed with GEI staff, B. Singh, N. Cholewinski, and LMA representative, J. Caruso. (H. Dunn – GEI) FIELD_STRUCT_DESC: 24-inch corrugated metal drainage pipe through the levee, 8 feet below the crown. Concrete U-shaped headwalls on both ends. Flap gate on the waterside (WS) end. Cobble grouted spillway across the berm. [Additional Reference(s): DWR Levee Log, 1987. USACE San Joaquin O&M Manual 612.1, June 1965, (HLM 3.09)]. FS Date: 2/17/2021

Levee crown looking upstream.

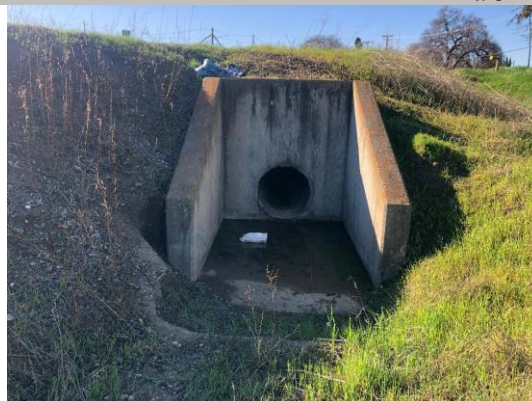
Photo 2 of 3 : UCIP_FA_2021_66466_91141.jpg

LS view: LS headwall at toe. Minor scouring on left side of headwall.

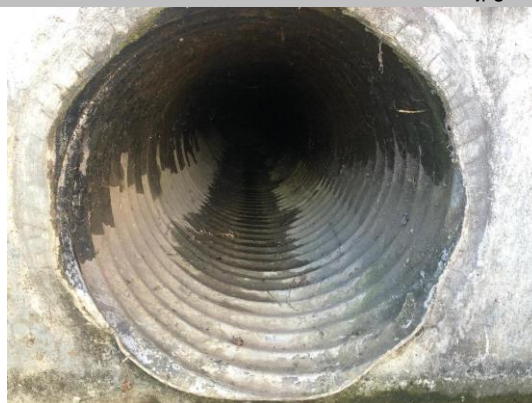
Photo 3 of 3 : UCIP_FA_2021_66466_91142.jpg

LS view: LS pipe.

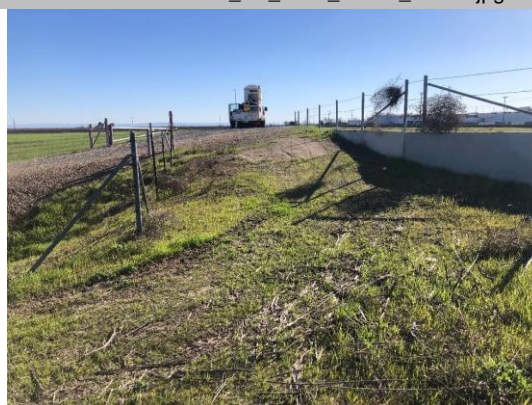
Photo 1 of 3 : UCIP_FA_2021_66468_91156.jpg

Levee crown looking upstream.

Comment Code					
Inspector Comment					
DS_ID:23526 FS_ID:66468 EP_NO: N/A Repair Type: Non-Urgent EVAL Issue: Unauthorized Encroachment, installed decades prior Crossing Status: Found UCIP Comments: 02/17/2021 Record was updated from No Action Needed to Non-Urgent. DWR DMP has not found internal issues, LOF between 1 and 2. Recommend inspection in 5 years. CVFPB will need to review crossing to determine owner. The UCIP inspection was completed with GEI staff, B. Singh, N. Cholewinski, and LMA representative, J. Caruso. (H. Dunn – GEI) FIELD_STRUCT_DESC: 24-inch corrugated metal storm drainage pipe through the levee, 7.5 feet below the crown. Concrete U-shaped headwalls on both ends. Flap gate on the waterside (WS) end. Cobble grouted spillway across the berm. [Additional Reference(s): DWR Levee Log, 1987. USACE San Joaquin O&M Manual 612.1, June 1965, (HLM 3.12) and 612 (addendum), February 1999, (HLM 3.15) (Station 166+25)]. FS Date: 2/17/2021

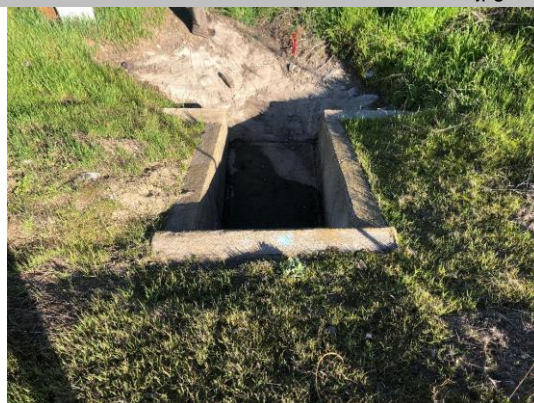
Photo 2 of 3 : UCIP_FA_2021_66468_91157.jpg

LS view: LS headwall at toe from crown.

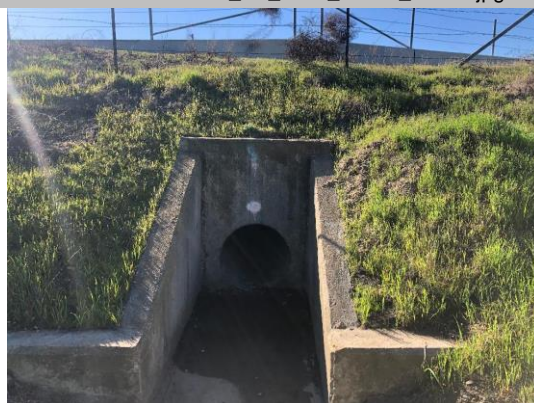
Photo 3 of 3 : UCIP_FA_2021_66468_91158.jpg

LS view: LS headwall at toe.

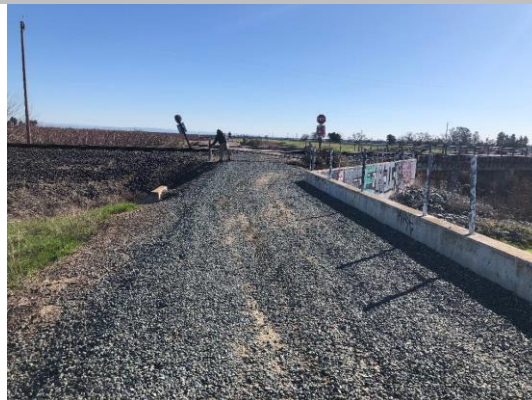
Photo 1 of 3 : UCIP_FA_2021_66469_95478.jpg

Comment Code						
Inspector Comment						
DS_ID:23528 FS_ID:66469 EP_NO: N/A Repair Type: Non-Urgent EVAL Issue: Unauthorized Encroachment, installed decades prior Crossing Status: Found UCIP Comments: 02/17/2021 Record was updated from No Action Needed to Non-Urgent. DWR DMP has not found internal issues, LOF between 1 and 2. Recommend inspection in 5 years. CVFPB will need to review crossing to determine owner. The UCIP inspection was completed with GEI staff, B. Singh, N. Cholewinski, and LMA representative, J. Caruso. (H. Dunn – GEI) FIELD_STRUCT_DESC: 42-inch corrugated metal drainage pipe through the levee, 7.3 feet below the crown. Concrete U-shaped headwall on both sides. Flap gate on the waterside (WS) end. Grouted intake on the landside (LS). Cobble grouted spillway across the berm. [Additional Reference(s): DWR Levee Log, 1987. USACE San Joaquin O&M Manual 612.1, June 1965, (HLM 3.36)]. FS Date: 2/17/2021

Levee crown looking upstream.

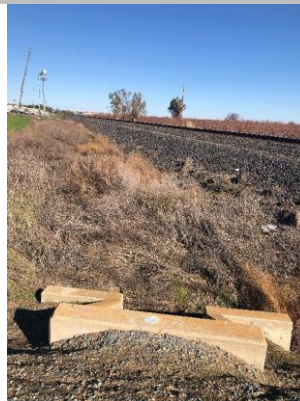
Photo 2 of 3 : UCIP_FA_2021_66469_95479.jpg

LS View: Headwall at toe from crown.

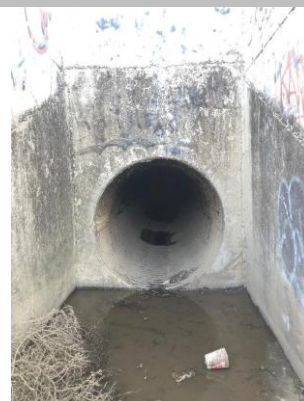
Photo 3 of 3 : UCIP_FA_2021_66469_95480.jpg

LS View: Pipe inlet.
