**Flood Control Project Maintenance
Levee Inspections**

Maintenance Issue Types Only, Levee Inspection Report By Mile - Fall 2021

San Joaquin County Flood Control and Water Conservation District

Waterway	Bank	Unit Miles	Inspection Start/End	Inspector
Unit No. 01 Littlejohn Creek	Left	2.59	10/21/2021 10/21/2021	Alberto De Leon

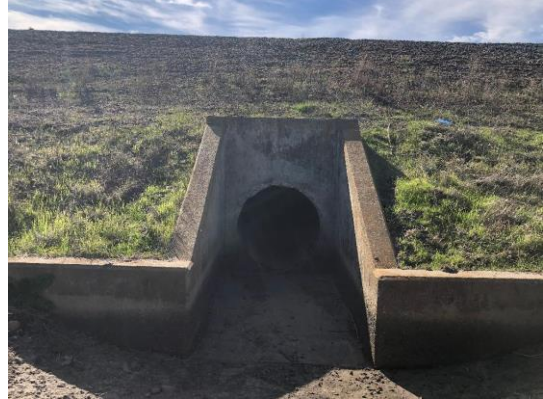
Photo 2 of 3 : UCIP_FA_2021_66347_93662.jpg

DS_ID:23532
 FS_ID:66347
 EP_NO: N/A
 Repair Type: Non-Urgent
 EVAL Issue: Pipe Damage
 Crossing Status: Found
 UCIP Comments: 02/17/2021 The record has been upgraded from No Action Needed to Non-Urgent. DWR DMP has found integrity issues, LOF between 4 and 5. Crossing will be monitored until funding becomes available for rehabilitation. Minor erosion underneath the grouted WS spillway. 2 feet in length, half foot in height. No permit was found authorizing this encroachment. CVFPB will need to review crossing to determine owner. The UCIP inspection was completed with GEI staff, B. Singh, N. Cholewinski, and LMA representative, J. Caruso. (H. Dunn – GEI)
 FIELD_STRUCT_DESC: 36-inch corrugated metal drainage pipe through the levee, 8.5 feet below the crown. Concrete U-shaped headwalls on both ends. Flap gate on the waterside (WS) end. Cobble grouted spillway across berm. [Additional Reference(s): DWR Levee Log, 1987. USACE San Joaquin O&M Manual 612.1, June 1965, (HLM 3.58)].

LS view: LS headwall at toe.

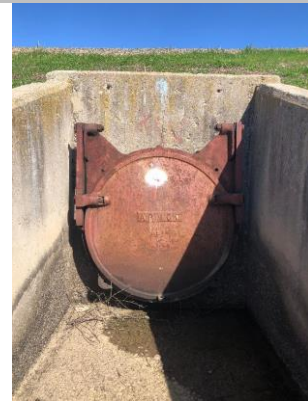
Photo 3 of 3 : UCIP_FA_2021_66347_95505.jpg

WS view: Headwall and close up view of flapgate.

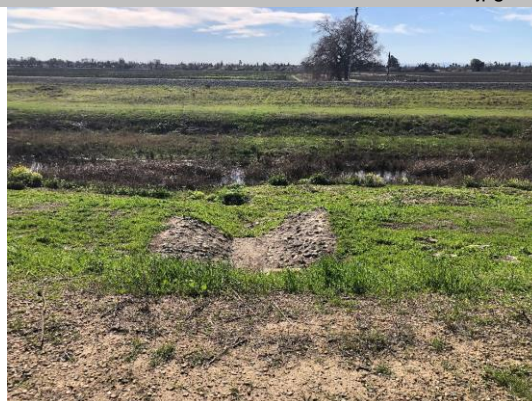
Photo 1 of 3 : UCIP_FA_2021_66479_93682.jpg

Comment Code						
Inspector Comment						
DS_ID:23533 FS_ID:66479 EP_NO: N/A Repair Type: Non-Urgent EVAL Issue: Unauthorized Encroachment, installed decades prior Crossing Status: Found UCIP Comments: 02/17/2021 The record has been upgraded from No Action Needed to Non-Urgent. DWR DMP has not found internal issues, LOF between 1 and 2. Recommend inspection in 5 years. No permit was found authorizing this encroachment. CVFPB will need to review crossing to determine owner. The UCIP inspection was completed with GEI staff, B. Singh, N. Cholewinski, and LMA representative, J. Caruso. (H. Dunn – GEI) FIELD_STRUCT_DESC: 24-inch corrugated metal drainage pipe through the levee, 7 feet below the crown. Concrete U-shaped headwalls on both ends. Flap gate on the waterside (WS) end. Slide gate on the landside (LS) end. Grouted intake on the LS. Cobble grouted spillway across berm. [Additional Reference(s): DWR Levee Log, 1987. USACE San Joaquin O&M Manual 612.1, June 1965, (HLM 3.81)]. FS Date: 2/17/2021

WS view: WS headwall at toe from crown.

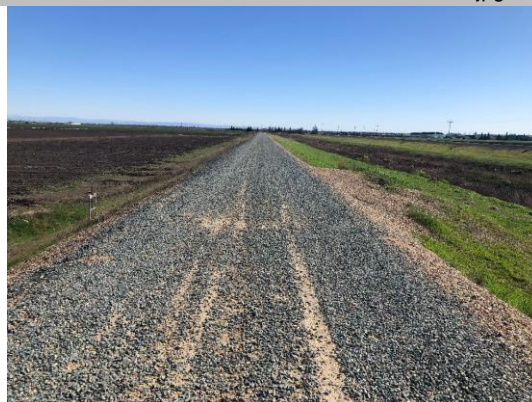
Photo 2 of 3 : UCIP_FA_2021_66479_93684.jpg

Levee crown looking upstream.

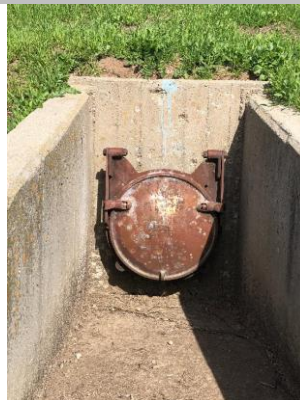
Photo 3 of 3 : UCIP_FA_2021_66479_95513.jpg

WS view: Headwall and close up of flapgate.

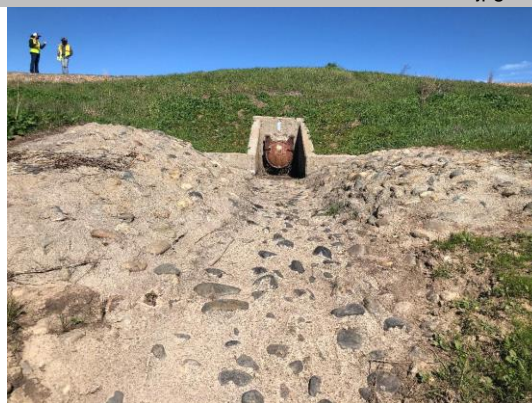
Photo 1 of 3 : UCIP_FA_2021_66870_93717.jpg

DS_ID:23534
 FS_ID:66870
 EP_NO: N/A
 Repair Type: Urgent
 EVAL Issue: Pipe Integrity
 Crossing Status: Found
 UCIP Comments: 02/17/2021 The record has been upgraded from No Action Needed to Urgent. DWR DMP has found integrity issues, LOF between 5 and 6. Crossing will be monitored until funding becomes available to be addressed. Holes and peeling of metal on the inside bottom of the LS pipe. Recommend LMA create contingency plan for increased inspections during high-water. No permit was found authorizing this encroachment. CVFPB will need to review crossing to determine owner. The UCIP inspection was completed with GEI staff, B. Singh, N. Cholewinski, and LMA representative, J. Caruso. (H. Dunn – GEI)
 FIELD_STRUCT_DESC: 24-inch corrugated metal storm drainage pipe through the levee, 7 feet below the crown. Concrete U-shaped headwalls on both ends. Flap gate on the waterside (WS) end. Slide gate on the landside (LS) end. Grouted intake on the LS. Cobble grouted spillway across the berm. [Additional Reference(s): DWR Levee Log, 1987. USACE San Joaquin O&M Manual 612.1, June 1965, (HLM 4.10) and 612 (addendum), February 1999, (HLM 4.10) (Station 216+43)].

WS view: WS headwall and flapgate at toe.

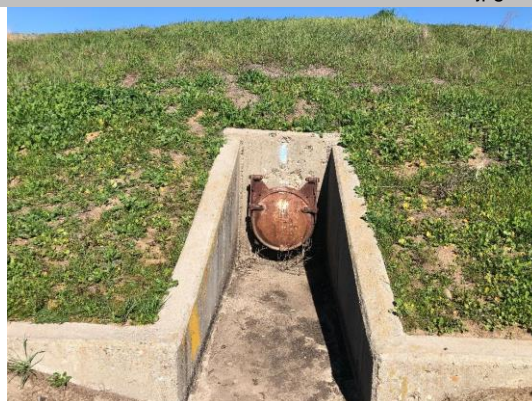
Photo 2 of 3 : UCIP_FA_2021_66870_93718.jpg

WS view: WS headwall and flapgate at toe.

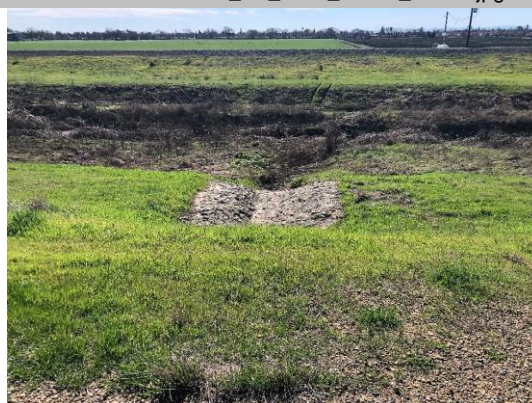
Photo 3 of 3 : UCIP_FA_2021_66870_93719.jpg

WS view: WS headwall at toe from crown.

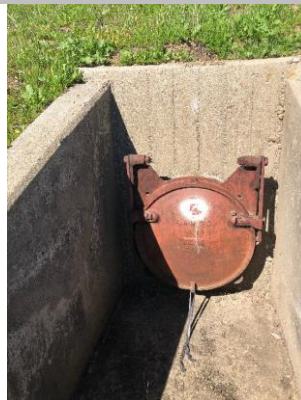
Photo 1 of 3 : UCIP_FA_2021_66485_95535.jpg

Comment Code						
Inspector Comment						
DS_ID:23535 FS_ID:66485 EP_NO: N/A Repair Type: Urgent EVAL Issue: Pipe Integrity Crossing Status: Found UCIP Comments: 02/17/2021 The record has been upgraded from No Action Needed to Urgent. DWR DMP has found integrity issues, LOF between 5 and 6. Crossing will be monitored until funding becomes available to be addressed. Recommend LMA to prepare contingency plan for increased inspections during high-water. No permit was found authorizing this encroachment. CVFPB will need to review crossing to determine owner. The UCIP inspection was completed with GEI staff, B. Singh, N. Cholewinski, and LMA representative, J. Caruso. (H. Dunn – GEI) FIELD_STRUCT_DESC: 24-inch corrugated metal storm drainage pipe through the levee, 8 feet below the crown. Concrete U-shaped headwalls on both ends. Flap gate on the waterside (WS) end. Grouted intake on the landside (LS). Cobble grouted spillway across the berm. [Additional Reference(s): DWR Levee Log, 1987. USACE San Joaquin O&M Manual 612.1, June 1965, (HLM 4.37) and 612 (addendum), February 1999, (HLM 4.33) (Station 228+58)]. FS Date: 2/17/2021

WS view: Headwall and close up of flapgate.

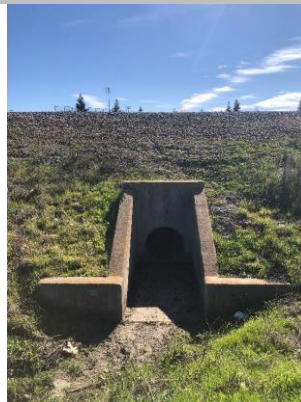
Photo 2 of 3 : UCIP_FA_2021_66485_95536.jpg

LS view: Headwall at toe.

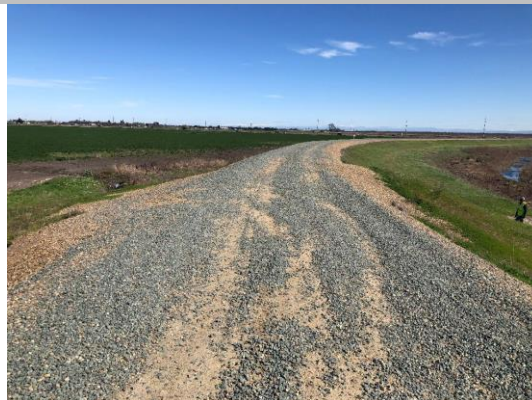
Photo 3 of 3 : UCIP_FA_2021_66485_93735.jpg

Levee crown looking upstream.

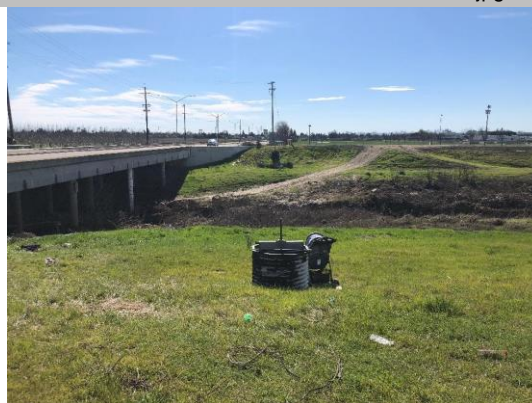
Photo 1 of 3 : UCIP_FA_2021_66486_93742.jpg

DS_ID:23536
 FS_ID:66486
 EP_NO: N/A
 Repair Type: Non-Urgent
 EVAL Issue: Safety Issue
 Crossing Status: Found
 UCIP Comments: 02/17/2021 The record has been upgraded from No Action Needed to Non-Urgent. LS concrete liner around riser is cracked and misaligned, as well as no cover. DWR DMP Geophysical study indicates possible presence of pipe through levee at 38.0444641, -121.2956106, coordinates have been updated. Owner needs to coordinate with the CVFPB to remove or abandon crossing according to Title 23 requirements. No permit was found authorizing this encroachment. CVFPB will need to review crossing to determine owner. The UCIP inspection was completed with GEI staff, B. Singh, N. Cholewinski, and LMA representative, J. Caruso. (H. Dunn – GEI)
 FIELD_STRUCT_DESC: 24-inch corrugated metal pipe siphon through the levee, 10.4 feet below the crown. Slide gate in 36-inch corrugated metal riser unit on the waterside (WS) slope. Siphon cleanout in center of channel. Slide gate in concrete standpipe at the landside (LS) toe.

WS view: WS toe from crown, metal riser with slidegate.

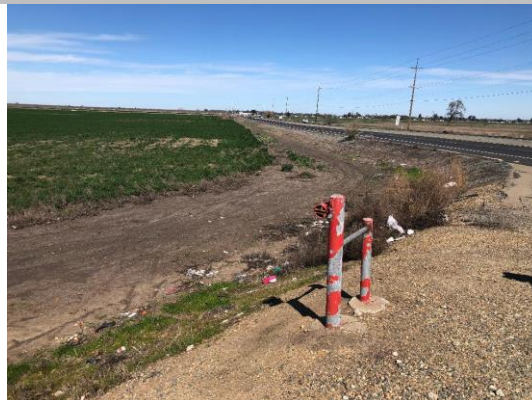
Photo 2 of 3 : UCIP_FA_2021_66486_93743.jpg

LS view: LS toe from crown, metal riser with slidegate.

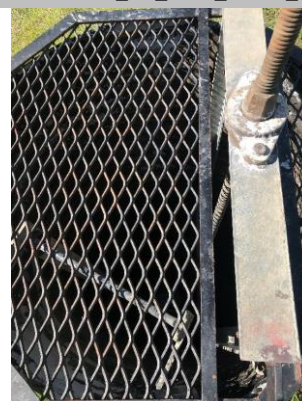
Photo 3 of 3 : UCIP_FA_2021_66486_95547.jpg

WS view: Inside metal riser with slidegate.

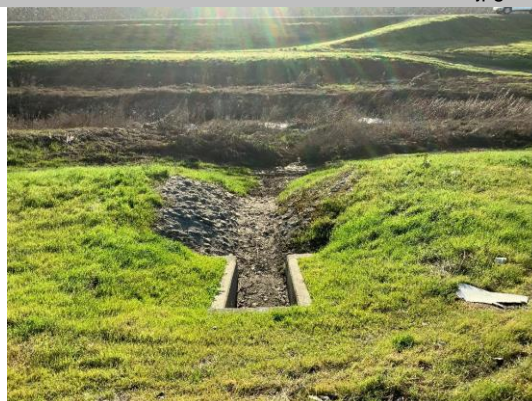
Photo 1 of 3 : UCIP_FA_2021_66490_91205.jpg

Comment Code					
Inspector Comment					
DS_ID:23538 FS_ID:66490 EP_NO: N/A Repair Type: Non-Urgent EVAL Issue: Unauthorized Encroachment, installed decades prior Crossing Status: Found UCIP Comments: 02/18/2021 The record has been upgraded from No Action Needed to Non-Urgent. DWR DMP has not found internal issues, LOF between 1 and 2. Recommend inspection in 5 years. True location was around 20 feet south, coordinates have been updated to 38.0450489, -121.2950334. No permit was found authorizing this encroachment. CVFPB will need to review crossing to determine owner. The UCIP inspection was completed with GEI staff, B. Singh and LMA representative, M. Mccoy. (H. Dunn – GEI) FIELD_STRUCT_DESC: 24-inch corrugated metal drainage pipe through the levee, 8.3 feet below the crown. Concrete U-shaped headwalls on both ends. Flap gate on the waterside (WS) end. Grouted intake on the landside (LS). Cobble grouted spillway across berm. [Additional Reference(s): DWR Levee Log, 1987. USACE San Joaquin O&M Manual 612.1, June 1965, (HLM 4.66)]. FS Date: 2/18/2021

WS view: WS headwall at toe from crown.

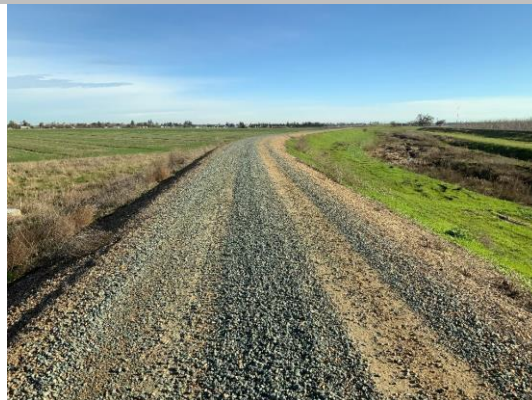
Photo 2 of 3 : UCIP_FA_2021_66492_91230.jpg

Levee crown looking upstream.

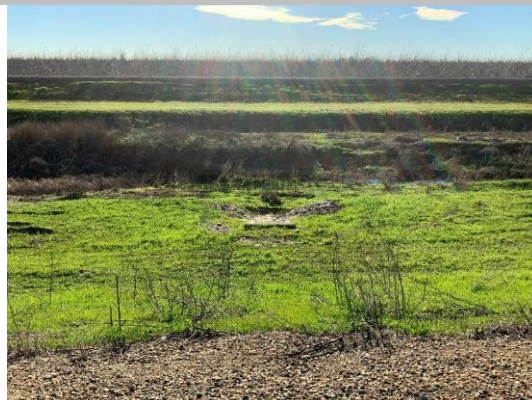
Photo 3 of 3 : UCIP_FA_2021_66492_91231.jpg

WS view: Headwall at WS toe from crown.

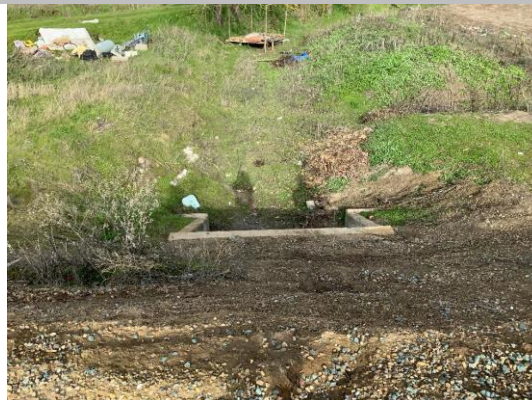
Photo 1 of 3 : UCIP_FA_2021_66501_91293.jpg

Comment Code						
Inspector Comment						
DS_ID:23543 FS_ID:66501 EP_NO: N/A Repair Type: Non-Urgent EVAL Issue: Pipe Damage Crossing Status: Found UCIP Comments: 02/18/2021 The record has been upgraded from No Action Needed to Non-Urgent. DWR DMP has found integrity issues, LOF between 4 and 5. Crossing will be monitored until funding becomes available for rehabilitation. No permit was found authorizing this encroachment. CVFPB will need to review crossing to determine owner. The UCIP inspection was completed with GEI staff, B. Singh and LMA representative, M. Mccoy. (H. Dunn – GEI) FIELD_STRUCT_DESC: 1 of 2: 36-inch corrugated metal storm drainage pipe through the levee, 8.9 feet below the crown. Concrete U-shaped headwall on both ends. Flap gate on the waterside (WS) end. Grouted intake on the landside (LS). Cobble grouted spillway across the berm. [Additional Reference(s): DWR Levee Log, 1987. USACE San Joaquin O&M Manual 612.1, June 1965, (HLM 5.33) and 612 (addendum), February 1999, (HLM 5.37) (Station 283+76)]. FS Date: 2/18/2021

LS view: LS headwall at toe from crown.

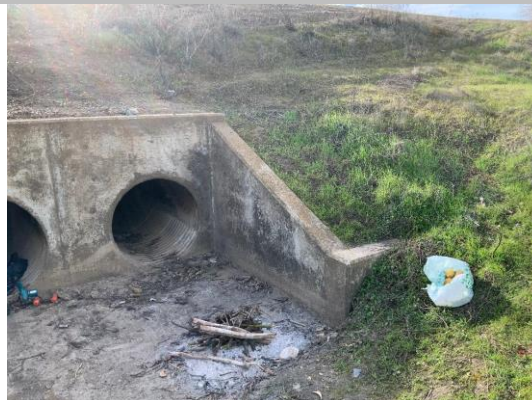
Photo 2 of 3 : UCIP_FA_2021_66501_91294.jpg

LS view: Left side headwall and pipe on LS toe.

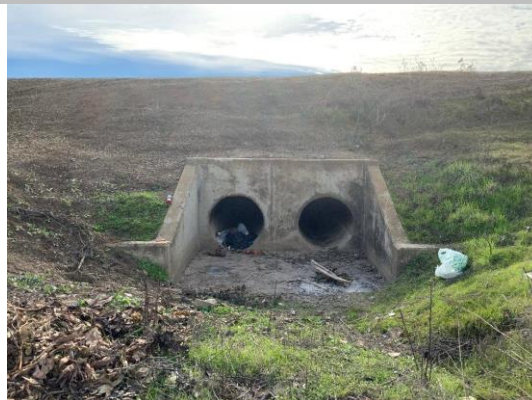
Photo 3 of 3 : UCIP_FA_2021_66501_91295.jpg

LS view: Headwall and pipes on LS toe.

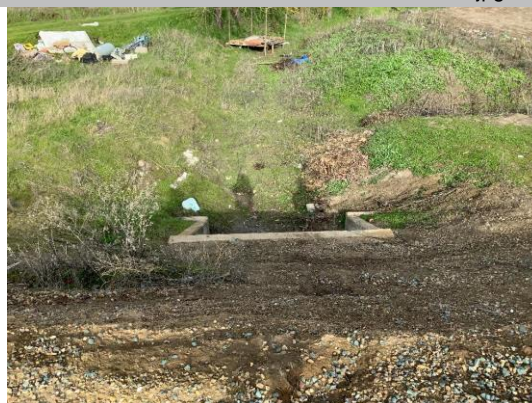
Photo 1 of 3 : UCIP_FA_2021_64042_91399.jpg

DS_ID:23678
 FS_ID:64042
 EP_NO: N/A
 Repair Type: Non-Urgent
 EVAL Issue: Unauthorized Encroachment, installed decades prior
 Crossing Status: Found
 UCIP Comments: 02/18/2021 Pipe status is still Non-Urgent. DWR DMP has not found internal issues, LOF between 1 and 2. Recommend inspection in 5 years. Minor debris inside LS pipe. No permit was found authorizing this encroachment. CVFPB will need to review crossing to determine owner. The UCIP inspection was completed with GEI staff, B. Singh and LMA representative, M. McCoy. (H. Dunn – GEI)
 FIELD_STRUCT_DESC: 2 of 2: 36-inch corrugated metal drainage pipe through the levee, 8.9 feet below the crown. Concrete U-shaped headwall on both ends. Flap gate on the waterside (WS) end. Grouted intake on the landside (LS). Cobble grouted spillway across the berm.
 [Additional Reference(s): DWR Levee Log, 1987. USACE San Joaquin O&M Manual 612.1, June 1965, (HLM 5.33)].

LS view: LS headwall at toe from crown.

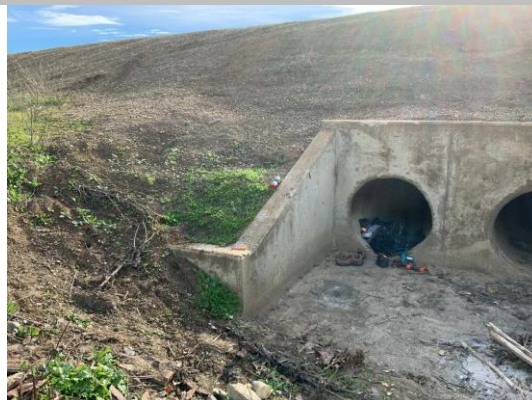
Photo 3 of 3 : UCIP_FA_2021_64042_91402.jpg

LS view: LS headwall and pipe at toe.

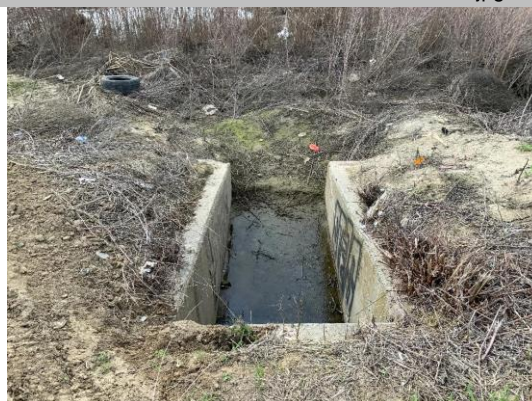
Photo 1 of 3 : UCIP_FA_2021_66503_91418.jpg

Comment Code					
Inspector Comment					
DS_ID:23544 FS_ID:66503 EP_NO: N/A Repair Type: Urgent EVAL Issue: Pipe Integrity Crossing Status: Found UCIP Comments: 02/18/2021 The record has been upgraded from No Action Needed to Urgent. Outside edges of WS pipe are warped with minor erosion on WS slope along pipe alignment. DWR DMP has found integrity issues, LOF between 5 and 6. Crossing will be monitored until funding becomes available to address. No permit was found authorizing this encroachment. CVFPB will need to review crossing to determine owner. The UCIP inspection was completed with GEI staff, B. Singh and LMA representative, M. Mccoy. (H. Dunn – GEI) FIELD_STRUCT_DESC: 36-inch corrugated metal storm drainage pipe through the levee, 10.6 feet below the crown. Concrete U-shaped headwall on the waterside (WS) end. Flap gate on the WS end. Cobble grouted spillway across the berm. [Additional Reference(s): DWR Levee Log, 1987. USACE San Joaquin O&M Manual 612.1, June 1965, (HLM 5.87) and 612 (addendum), February 1999, (HLM 5.81) (Station 306+88)]. FS Date: 2/18/2021

WS view: WS headwall at toe from crown.

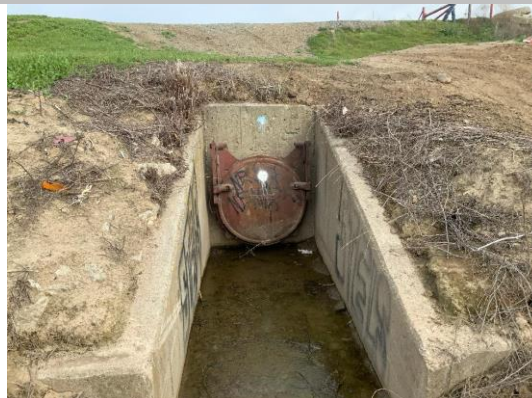
Photo 2 of 3 : UCIP_FA_2021_66503_91419.jpg

WS view: WS headwall and flagate at toe.

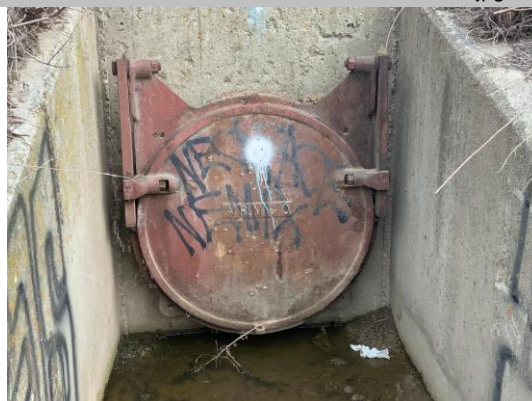
Photo 3 of 3 : UCIP_FA_2021_66503_91415.jpg

WS view: WS flapgate.

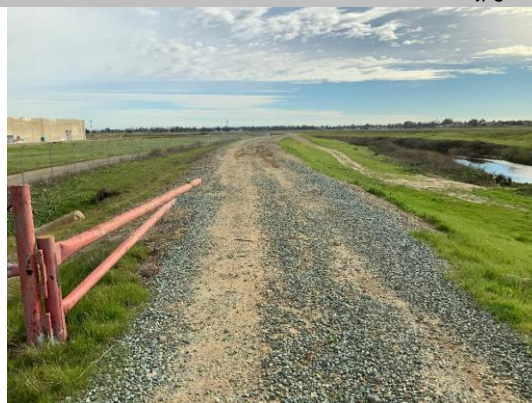
Photo 1 of 3 : UCIP_FA_2021_66869_91732.jpg

Levee crown looking upstream.

Comment Code					
Inspector Comment					
DS_ID:23545 FS_ID:66869 EP_NO: N/A Repair Type: Non-Urgent EVAL Issue: Pipe Damage Crossing Status: Found UCIP Comments: 02/18/2021 Pipe status is still Non-Urgent. Bullet holes seen through LS flapgate compromising effectiveness. LMA stated they would have the holes welded shut within 2 years. DWR DMP has found integrity issues, LOF between 4 and 5. Crossing will be monitored until funding becomes available for rehabilitation. No permit was found authorizing this encroachment. CVFPB will need to review crossing to determine owner. The UCIP inspection was completed with GEI staff, B. Singh and LMA representative, M. McCoy. (H. Dunn – GEI) 05/15/2014 Some sediment buildup inside pipe. (W. Wylie - DWR UCIP) FIELD_STRUCT_DESC: 24-inch corrugated metal drainage pipe through the levee, 6.9 feet below the crown. Concrete U-shaped headwalls on both ends. Flap gate on the waterside (WS) end. Grouted intake on the landside (LS). Cobble grouted spillway across berm. [Additional Reference(s): DWR Levee Log, 1987. USACE San Joaquin O&M Manual 612.1, June 1965, (HLM 5.90)]. FS Date: 2/18/2021

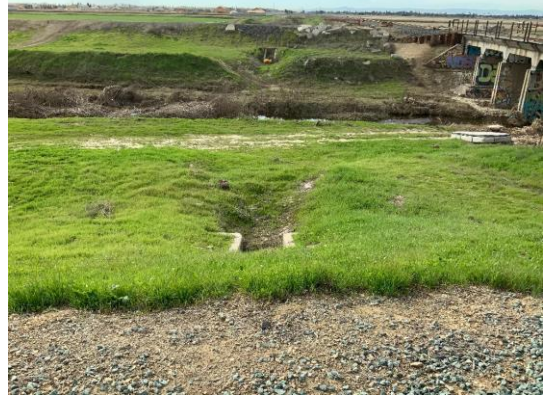
Photo 2 of 3 : UCIP_FA_2021_66869_91733.jpg

WS view: WS headwall at toe from crown.

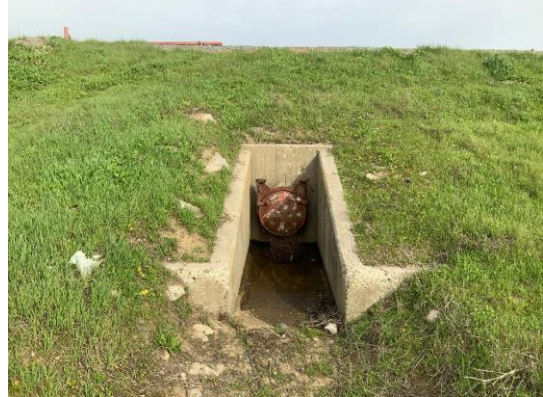
Photo 3 of 3 : UCIP_FA_2021_66869_91734.jpg

WS view: WS headwall and flapgate at toe.

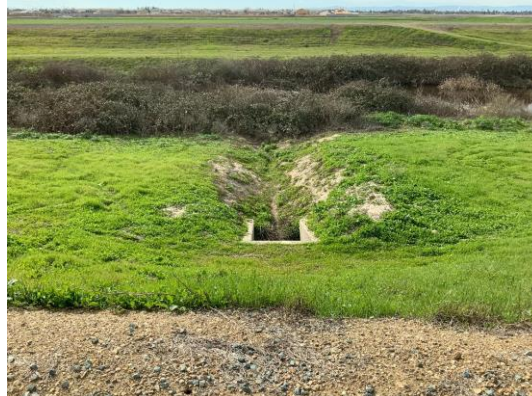
Photo 1 of 3 : UCIP_FA_2021_66509_91739.jpg

Comment Code						
Inspector Comment						
DS_ID:23546 FS_ID:66509 EP_NO: N/A Repair Type: Urgent EVAL Issue: Pipe Integrity Crossing Status: Found UCIP Comments: 02/18/2021 The record has been upgraded from Non-Urgent to Urgent. No LS pipe visible, and LMA has confirmed that the pipe is abandoned, has been grouted, and will be removed within 5 years. DWR DMP has found integrity issues, LOF between 5 and 6. Crossing will be monitored until funding becomes available for it to be addressed. No permit was found authorizing this encroachment. CVFPB will need to review crossing to determine owner. The UCIP inspection was completed with GEI staff, B. Singh and LMA representative, M. McCoy. (H. Dunn – GEI) 05/15/2014 Inlet buried at LS toe. Pipe may be abandoned and if so should be done so properly. (W. Wylie - DWR UCIP) FIELD_STRUCT_DESC: *ABANDONED* 36-inch corrugated metal drainage pipe through the levee, 7.9 feet below the crown. Concrete U-shaped headwall on the waterside (WS) end. Concrete headwall on the landside (LS). Flap gate on the WS end. Cobble grouted spillway across the berm. [Additional Reference(s): DWR Levee Log, 1987. USACE San Joaquin O&M Manual 612.1, June 1965, (HLM 5.97)]. FS Date: 2/18/2021

WS view: WS headwall at toe from crown.

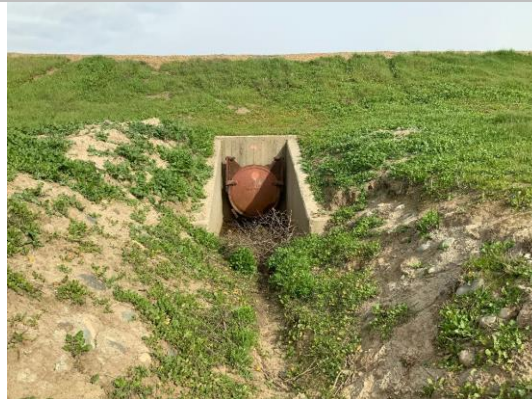
Photo 2 of 3 : UCIP_FA_2021_66509_91740.jpg

WS view: WS headwall and flapgate at toe.

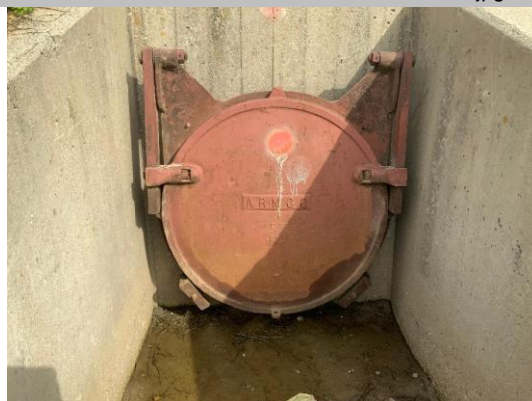
Photo 3 of 3 : UCIP_FA_2021_66509_91737.jpg

WS view: WS flapgate at toe.

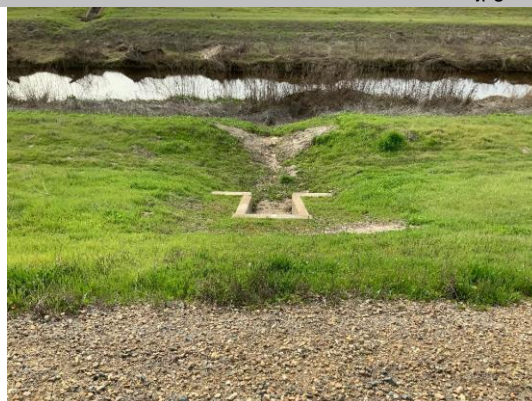
Photo 1 of 3 : UCIP_FA_2021_66523_91770.jpg

DS_ID:23550
FS_ID:66523
EP_NO: N/A
Repair Type: Urgent
EVAL Issue: Pipe Integrity
Crossing Status: Found
UCIP Comments: 02/18/2021 The record has been upgraded from No Action Needed to Urgent. DWR DMP has found integrity issues, LOF between 5 and 6. Crossing will be monitored until funding becomes available for it to be addressed. No permit was found authorizing this encroachment. CVFPB will need to review crossing to determine owner. The UCIP inspection was completed with GEI staff, B. Singh and LMA representative, M. McCoy. (H. Dunn – GEI)
FIELD_STRUCT_DESC: 24-inch corrugated metal drainage pipe through the levee, 5.9 feet below the crown. Concrete U-shaped headwalls on both ends. Flap gate on the waterside (WS) end. Grouted intake on the landside (LS). Cobble grouted spillway across the berm.
[Additional Reference(s): DWR Levee Log, 1987. USACE San Joaquin O&M Manual 612.1, June 1965, (HLM 6.20)].

WS view: WS headwall at toe from crown.

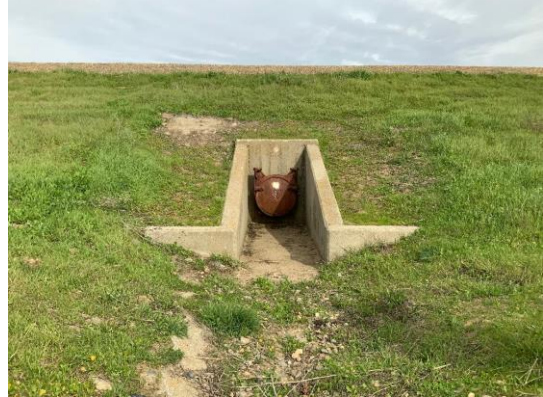
Photo 2 of 3 : UCIP_FA_2021_66523_91771.jpg

WS view: WS headwall and flapgate at toe.

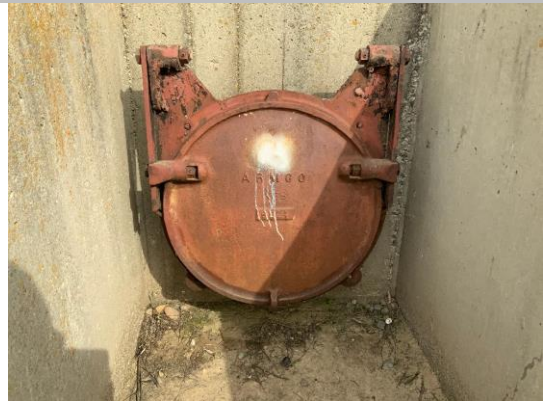
Photo 3 of 3 : UCIP_FA_2021_66523_91772.jpg

WS view: WS flapgate at toe.

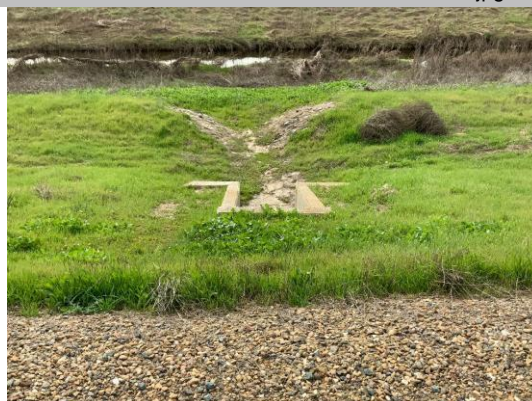
Photo 1 of 3 : UCIP_FA_2021_66524_91777.jpg

Comment Code						
Inspector Comment						
DS_ID:23551 FS_ID:66524 EP_NO: N/A Repair Type: Non-Urgent EVAL Issue: Pipe Damage Crossing Status: Found UCIP Comments: 02/18/2021 Pipe status is still Non-Urgent. DWR DMP has found integrity issues, LOF between 4 and 5. Crossing will be monitored until funding becomes available for rehabilitation. No permit was found authorizing this encroachment. CVFPB will need to review crossing to determine owner. The UCIP inspection was completed with GEI staff, B. Singh and LMA representative, M. McCoy. (H. Dunn – GEI) 05/15/2014 Sediment buildup in pipe at LS toe. (W. Wylie - DWR UCIP) FIELD_STRUCT_DESC: 24-inch corrugated metal storm drainage pipe through the levee, 5.5 feet below the crown. Concrete U-shaped headwalls on both ends. Flap gate on the waterside (WS) end. Grouted intake on the landside (LS). Cobble grouted spillway across the berm. [Additional Reference(s): DWR Levee Log, 1987. USACE San Joaquin O&M Manual 612.1, June 1965, (HLM 6.32) and 612 (addendum), February 1999, (HLM 6.34) (Station 334+54), listed as a 36-inch pipe]. FS Date: 2/18/2021

WS view: WS headwall at toe from crown.

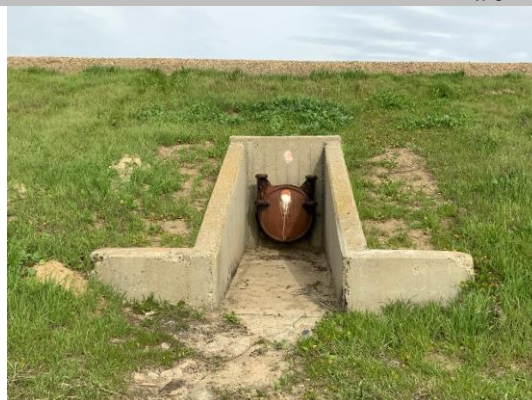
Photo 2 of 3 : UCIP_FA_2021_66524_91778.jpg

WS view: WS headwall and flapgate at toe.

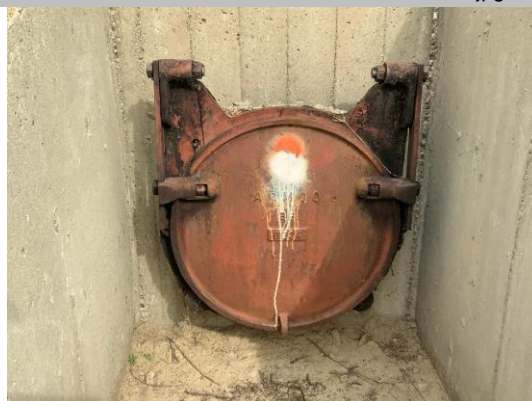
Photo 3 of 3 : UCIP_FA_2021_66524_91779.jpg

WS view: WS flapgate at toe.

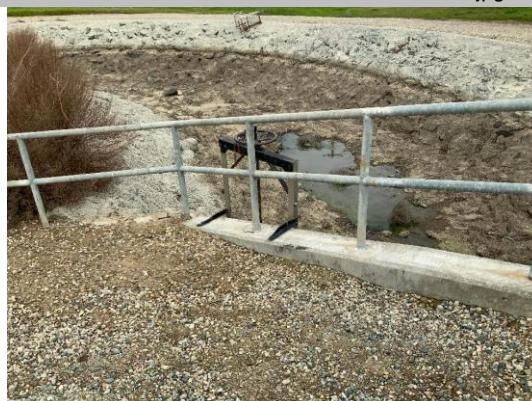
Photo 1 of 3 : UCIP_FA_2021_66529_91804.jpg

DS_ID:23552
 FS_ID:66529
 EP_NO: N/A
 Repair Type: Non-Urgent
 EVAL Issue: Levee Damage or Threat for Levee Damage
 Crossing Status: Found
 UCIP Comments: 02/18/2021 The record has been upgraded from No Action Needed to Non-Urgent. DWR DMP has not found internal issues, LOF between 1 and 2. Recommend inspection in 5 years. Cracking in soil on WS berm (4 feet), recommend monitoring area for material loss. No permit was found authorizing this encroachment. CVFPB will need to review crossing to determine owner. The UCIP inspection was completed with GEI staff, B. Singh and LMA representative, M. McCoy. (H. Dunn – GEI)
 FIELD_STRUCT_DESC: 24-inch corrugated metal storm drainage pipe through the levee, 6.4 feet below the crown. Concrete U-shaped headwall on the waterside (WS) end. Flap gate on the WS end. Cobble grouted spillway across the berm. Slide gate on the landside (LS) end. [Additional Reference(s): DWR Levee Log, 1987. USACE San Joaquin O&M Manual 612.1, June 1965, (HLM 6.51) and 612 (addendum), February 1999, (HLM 6.51) (Station 343+82)].

LS view: LS headwall at toe from crown.

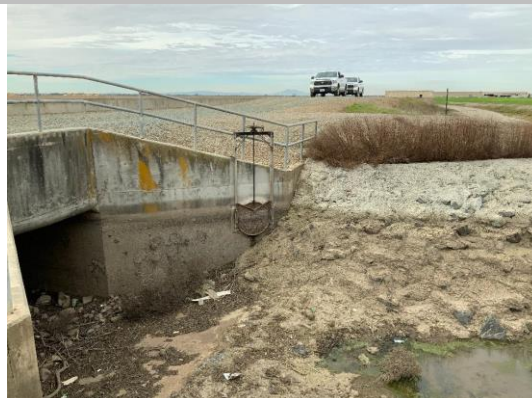
Photo 2 of 3 : UCIP_FA_2021_66529_91805.jpg

LS view: LS headwall and slide gate at toe.

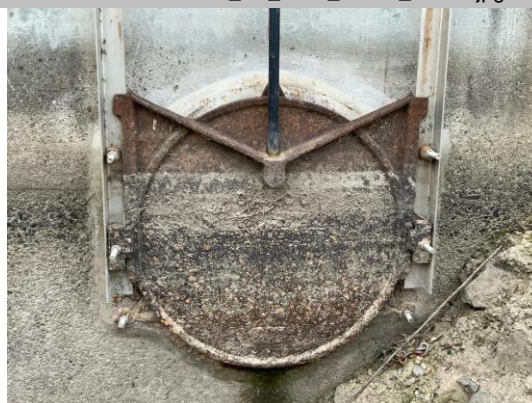
Photo 3 of 3 : UCIP_FA_2021_66529_91806.jpg

LS view: LS slide gate at toe.

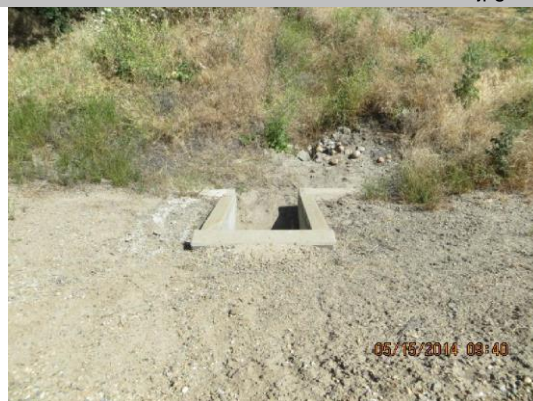
Photo 1 of 3 : UCIP_FA_2021_66531_68873.jpg

Comment Code						
Inspector Comment						
DS_ID:23554 FS_ID:66531 EP_NO: N/A Repair Type: Non-Urgent EVAL Issue: Pipe Damage Crossing Status: Found UCIP Comments: 02/18/2021 The record has been upgraded from No Action Needed to Non-Urgent. DWR DMP has found integrity issues, LOF between 4 and 5. Crossing will be monitored until funding becomes available for rehabilitation. No permit was found authorizing this encroachment. CVFPB will need to review crossing to determine owner. The UCIP inspection was completed with GEI staff, B. Singh and LMA representative, M. Mccoy. (H. Dunn – GEI) FIELD_STRUCT_DESC: 24-inch corrugated metal drainage pipe through the levee, 5.3 feet below the crown. Concrete U-shaped headwalls on both ends. Flap gate on the waterside (WS) end. Grouted intake on the landside (LS). Cobble grouted spillway across the berm. [Additional Reference(s): DWR Levee Log, 1987. USACE San Joaquin O&M Manual 612.1, June 1965, (HLM 6.53)]. FS Date: 2/18/2021

Headwall on LS toe.

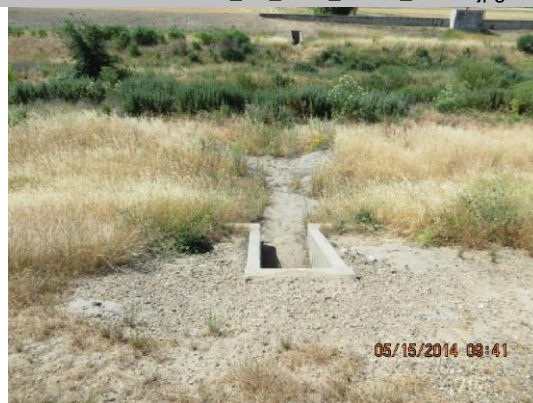
Photo 2 of 3 : UCIP_FA_2021_66531_68872.jpg

Headwall, flapgate, and grouted spillway on WS toe.

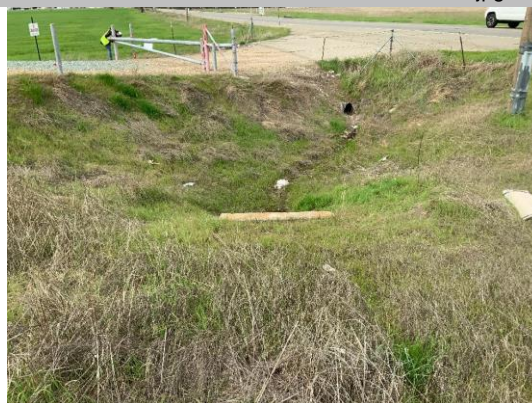
Photo 1 of 3 : UCIP_FA_2021_66534_91834.jpg

DS_ID:23555
 FS_ID:66534
 EP_NO: N/A
 Repair Type: Non-Urgent
 EVAL Issue: Pipe Damage
 Crossing Status: Found
 UCIP Comments: 02/18/2021 The record has been upgraded from No Action Needed to Non-Urgent. DWR DMP has found integrity issues, LOF between 4 and 5. Crossing will be monitored until funding becomes available for rehabilitation. No permit was found authorizing this encroachment. CVFPB will need to review crossing to determine owner. The UCIP inspection was completed with GEI staff, B. Singh and LMA representative, M. McCoy. (H. Dunn – GEI)
 FIELD_STRUCT_DESC: 24-inch corrugated metal drainage pipe through the levee, 6.7 feet below the crown. Concrete U-shaped headwalls on both ends. Flap gate on the waterside (WS) end. Grouted intake on the landside (LS). Cobble grouted spillway across the berm.
 [Additional Reference(s): DWR Levee Log, 1987. USACE San Joaquin O&M Manual 612.1, June 1965, (HLM 6.85)].

LS view: LS headwall at toe from crown.

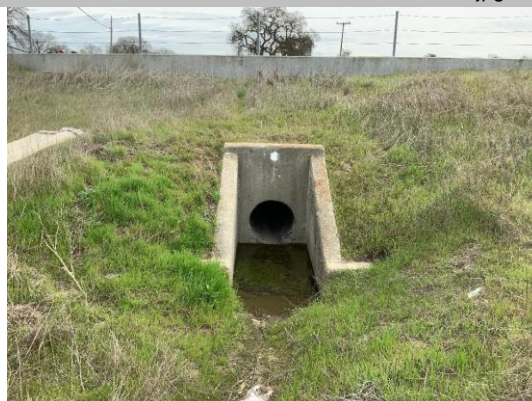
Photo 2 of 3 : UCIP_FA_2021_66534_91835.jpg

LS view: LS headwall at toe.

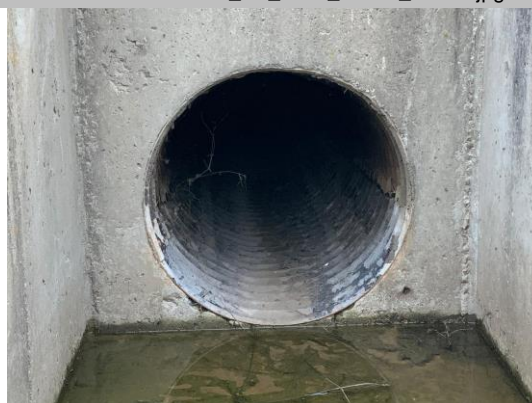
Photo 3 of 3 : UCIP_FA_2021_66534_91836.jpg

LS view: LS pipe.

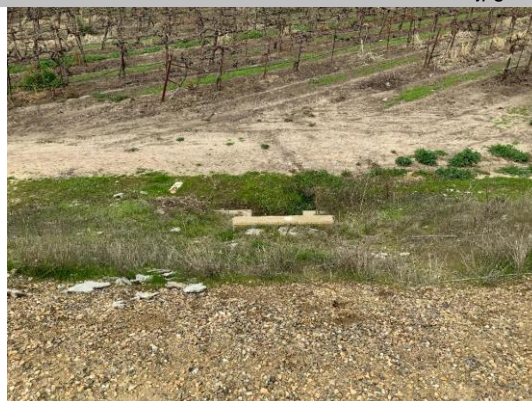
Photo 1 of 3 : UCIP_FA_2021_66537_91851.jpg

Comment Code						
Inspector Comment						
DS_ID:23557						
FS_ID:66537						
EP_NO: N/A						
Repair Type: Non-Urgent						
EVAL Issue: Pipe Damage						
Crossing Status: Found						
UCIP Comments: 02/18/2021 The record has been upgraded from No Action Needed to Non-Urgent. DWR DMP has found integrity issues, LOF between 4 and 5. Crossing will be monitored until funding becomes available for rehabilitation. No permit was found authorizing this encroachment. CVFPB will need to review crossing to determine owner. The UCIP inspection was completed with GEI staff, B. Singh and LMA representative, M. Mccoy. (H. Dunn – GEI)						
FIELD_STRUCT_DESC: 24-inch corrugated metal storm drainage pipe through the levee, 6.5 feet below the crown. Concrete U-shaped headwalls on both ends. Flap gate on the waterside (WS) end. Cobble grouted spillway across the berm. Culvert with slide gate in WID headwall on the WS. [Additional Reference(s): DWR Levee Log, 1987. USACE San Joaquin O&M Manual 612.1, June 1965, (HLM 7.02) and 612 (addendum), February 1999, (HLM 6.97) (Station 368+08)].

LS view: LS headwall at toe from crown.

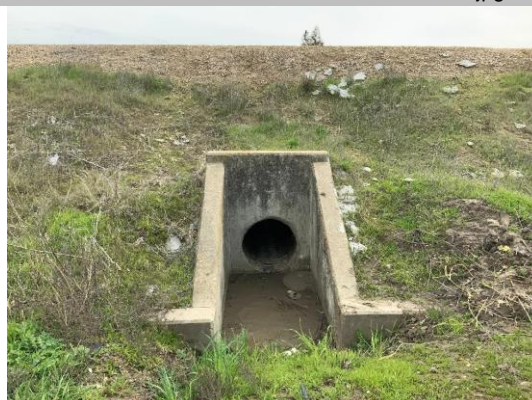
Photo 2 of 3 : UCIP_FA_2021_66537_91852.jpg

LS view: LS headwall at toe.

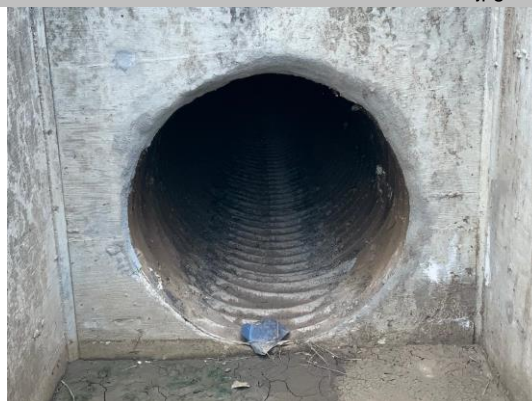
Photo 3 of 3 : UCIP_FA_2021_66537_91853.jpg

LS view: LS pipe.

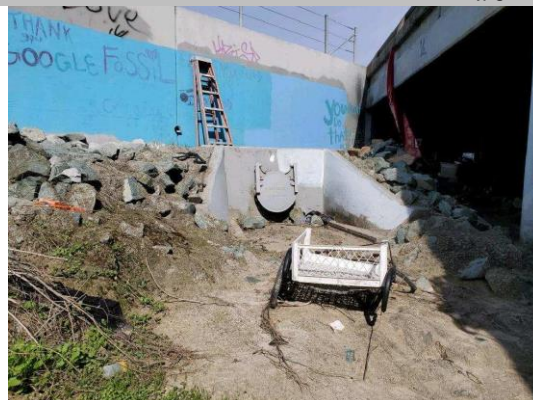
Photo 2 of 3 : UCIP_FA_2021_66540_91860.jpg

Comment Code						
Inspector Comment						
DS_ID:23559 FS_ID:66540 EP_NO: N/A Repair Type: Urgent EVAL Issue: Pipe Integrity Crossing Status: Found UCIP Comments: 02/24/2021 The record has been upgraded from No Action Needed to Urgent. Did not inspect LS due to safety issues (large homeless encampment under freeway). DWR DMP has found integrity issues, LOF between 5 and 6. Crossing will be monitored until funding becomes available to address the issues. No permit was found authorizing this encroachment. CVFPB will need to review crossing to determine owner. The UCIP inspection was completed with GEI staff, B. Singh. (H. Dunn – GEI) FIELD_STRUCT_DESC: 24-inch corrugated metal drainage pipe through the levee, 9 feet below the crown. Concrete U-shaped headwalls on both ends. Flap gate on the waterside (WS) end. Cobble grouted spillway across berm. Cobble grouted apron on the landside (LS) end. [Additional Reference(s): DWR Levee Log, 1987. USACE San Joaquin O&M Manual 612.1, June 1965, (HLM 7.14) 8-inch pipe listed]. FS Date: 2/24/2021

WS headwall and flapgate at toe.

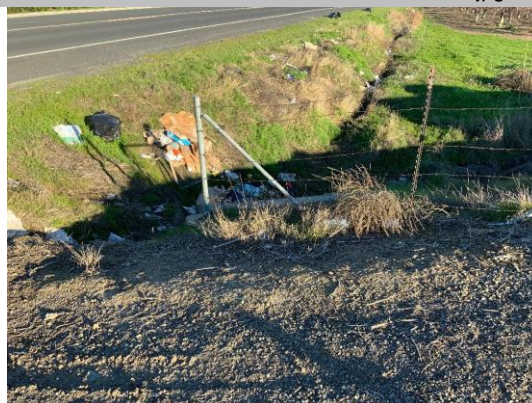
Photo 1 of 3 : UCIP_FA_2021_66542_91867.jpg

DS_ID:23561
FS_ID:66542
EP_NO: N/A
Repair Type: Non-Urgent
EVAL Issue: Levee Damage or Threat for Levee Damage
Crossing Status: Found
UCIP Comments: 02/24/2021 The record has been upgraded from No Action Needed to Non-Urgent. Minor erosion along the right edge of the LS headwall and slope. DWR DMP has not found internal issues, LOF between 1 and 2. Recommend inspection in 5 years. No permit was found authorizing this encroachment. CVFPB will need to review crossing to determine owner. The UCIP inspection was completed with GEI staff, B. Singh. (H. Dunn – GEI)
FIELD_STRUCT_DESC: 36-inch concrete drainage pipe through the levee, 8 feet below the crown. Concrete U-shaped headwalls on both ends. Flap gate on the waterside (WS) end. Cobble grouted spillway across berm. Cobble grouted apron on the landside (LS) end.
[Additional Reference(s): DWR Levee Log, 1987. USACE San Joaquin O&M Manual 612.2, 1967, (HLM 7.21)].

LS headwall at toe from crown.

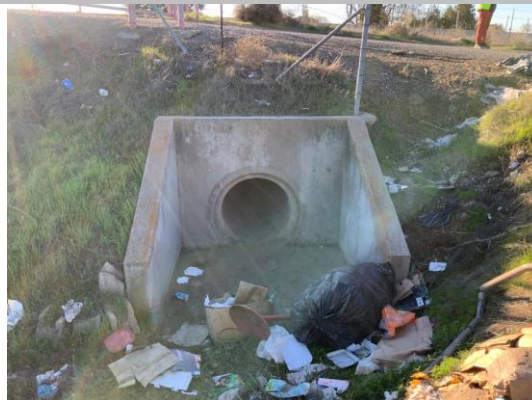
Photo 2 of 3 : UCIP_FA_2021_66542_91868.jpg

LS headwall at toe.

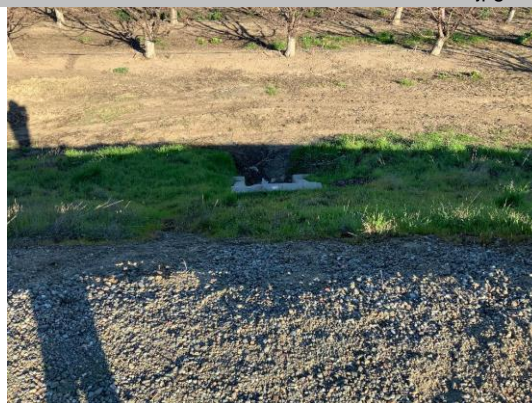
Photo 1 of 3 : UCIP_FA_2021_66544_91882.jpg

Comment Code					
Inspector Comment					
DS_ID:23562 FS_ID:66544 EP_NO: N/A Repair Type: Non-Urgent EVAL Issue: Pipe Damage Crossing Status: Found UCIP Comments: 02/24/2021 The record has been upgraded from No Action Needed to Non-Urgent. Concrete lining chipping off inside of LS pipe. DWR DMP has found integrity issues, LOF between 4 and 5. Crossing will be monitored until funding becomes available for rehabilitation. No permit was found authorizing this encroachment. CVFPB will need to review crossing to determine owner. The UCIP inspection was completed with GEI staff, B. Singh. (H. Dunn – GEI) FIELD_STRUCT_DESC: 24-inch corrugated metal storm drainage pipe through the levee, 8 feet below the crown. Concrete U-shaped headwalls on both ends. Flap gate on the waterside (WS) end. Cobble grouted spillway across the berm. Cobble grouted apron on the landside (LS) end. [Additional Reference(s): DWR Levee Log, 1987. USACE San Joaquin O&M Manual 612.2, 1967, (HLM 7.34) and 612 (addendum), February 1999, (HLM 7.30) (Station 385+65)]. FS Date: 2/24/2021

LS view: LS headwall at toe from crown.

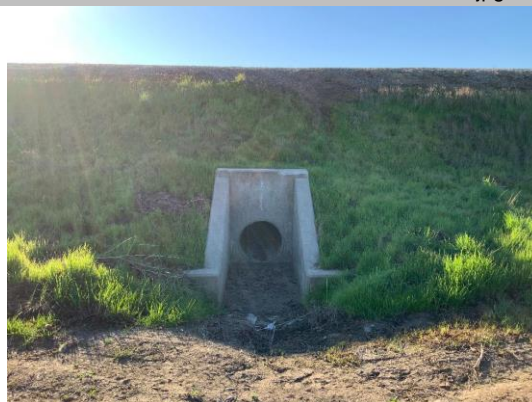
Photo 2 of 3 : UCIP_FA_2021_66544_91883.jpg

LS view: LS headwall at toe.

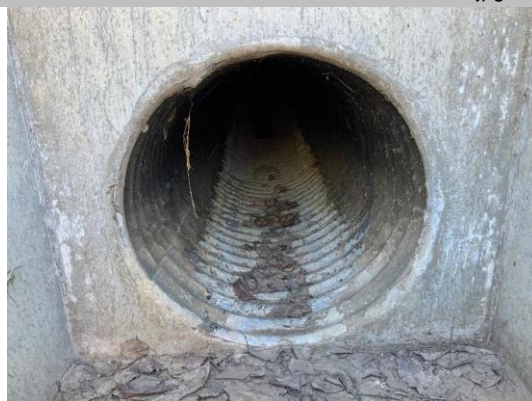
Photo 3 of 3 : UCIP_FA_2021_66544_91884.jpg

LS view: LS pipe.

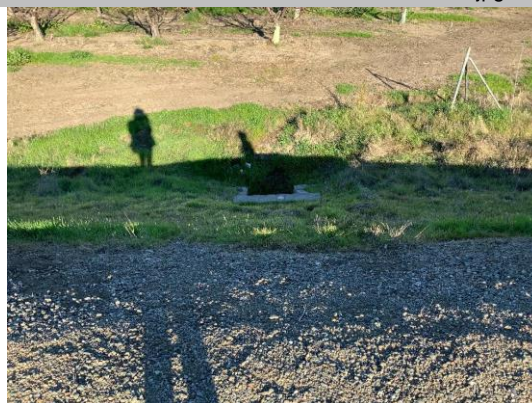
Photo 1 of 3 : UCIP_FA_2021_64078_91889.jpg

DS_ID:23563
 FS_ID:64078
 EP_NO: N/A
 Repair Type: Non-Urgent
 EVAL Issue: Unauthorized Encroachment, installed decades prior
 Crossing Status: Found
 UCIP Comments: 02/24/2021 The record has been upgraded from No Action Needed to Non-Urgent. DWR DMP has not found internal issues, LOF between 1 and 2. Recommend inspection in 5 years. No permit was found authorizing this encroachment. CVFPB will need to review crossing to determine owner. The UCIP inspection was completed with GEI staff, B. Singh. (H. Dunn – GEI)
 FIELD_STRUCT_DESC: 24-inch corrugated metal storm drainage pipe through the levee, 7 feet below the crown. Concrete U-shaped headwalls on both ends. Flap gate on the waterside (WS) end. Cobble grouted spillway across berm. Cobble grouted apron on the landside (LS) end. [Additional Reference(s): DWR Levee Log, 1987. USACE San Joaquin O&M Manual 612.2, 1967, (HLM 7.51) and 612 (addendum), February 1999, (HLM 7.45) (Station 393+26)].

LS headwall at toe from crown.

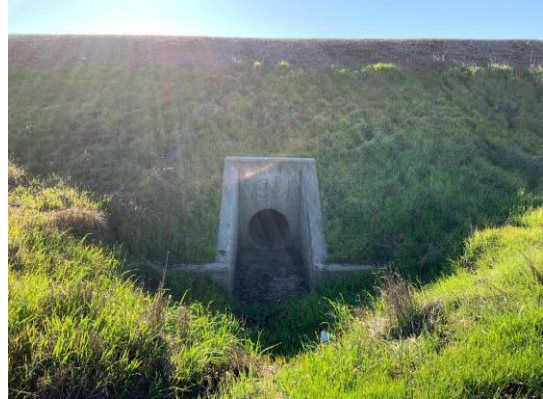
Photo 2 of 3 : UCIP_FA_2021_64078_91890.jpg

LS headwall at toe.

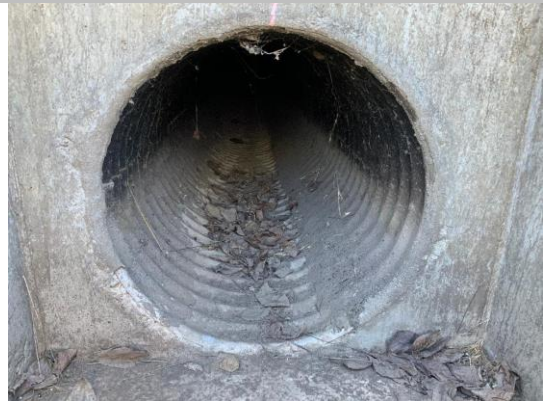
Photo 3 of 3 : UCIP_FA_2021_64078_91891.jpg

LS pipe.

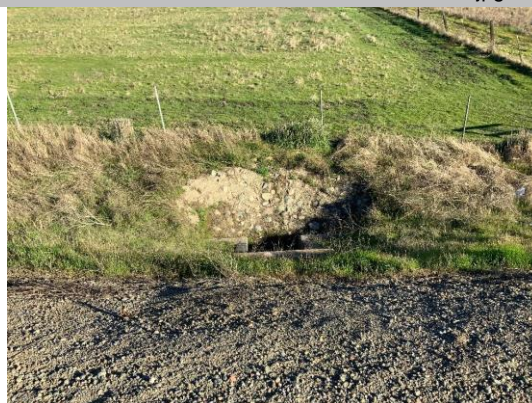
Photo 1 of 3 : UCIP_FA_2021_64079_91896.jpg

Comment Code						
Inspector Comment						
DS_ID:23564 FS_ID:64079 EP_NO: N/A Repair Type: Non-Urgent EVAL Issue: Unauthorized Encroachment, installed decades prior Crossing Status: Found UCIP Comments: 02/24/2021 The record has been upgraded from No Action Needed to Non-Urgent. DWR DMP has not found internal issues, LOF between 1 and 2. Recommend inspection in 5 years. No permit was found authorizing this encroachment. CVFPB will need to review crossing to determine owner. The UCIP inspection was completed with GEI staff, B. Singh. (H. Dunn – GEI) FIELD_STRUCT_DESC: 24-inch corrugated metal drainage pipe through the levee, 7.5 feet below the crown. Concrete U-shaped headwalls on both ends. Flap gate on the waterside (WS) end. Cobble grouted spillway across the berm. Cobble grouted apron on the landside (LS) end. [Additional Reference(s): DWR Levee Log, 1987. USACE San Joaquin O&M Manual 612.2, 1967, (HLM 7.72)]. FS Date: 2/24/2021

LS view: LS headwall at toe from crown.

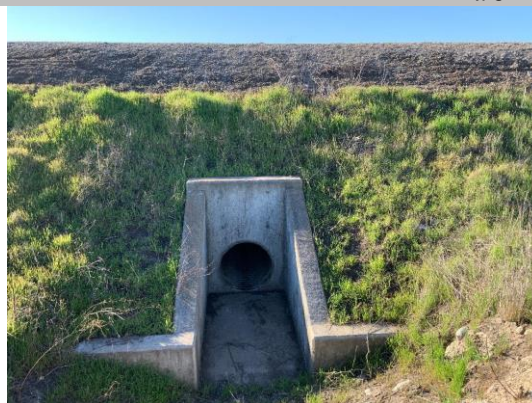
Photo 2 of 3 : UCIP_FA_2021_64079_91897.jpg

LS view: LS headwall at toe.

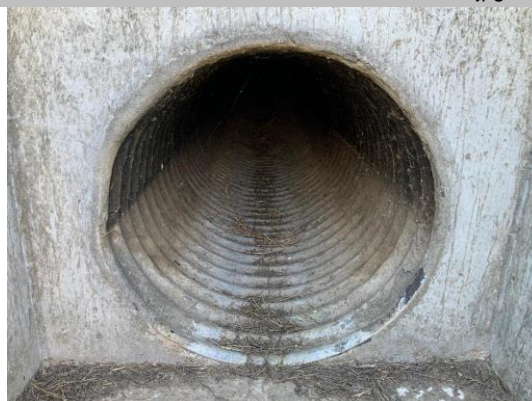
Photo 3 of 3 : UCIP_FA_2021_64079_91898.jpg

LS view: LS pipe.

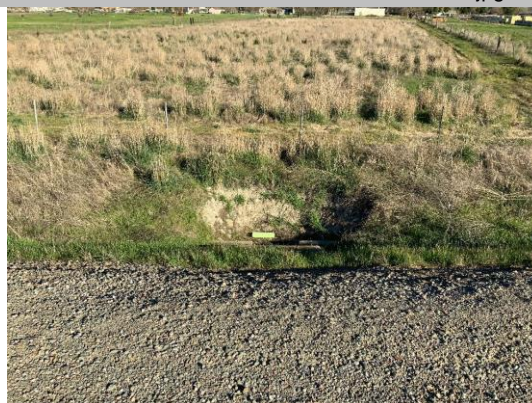
Photo 1 of 3 : UCIP_FA_2021_66545_91904.jpg

DS_ID:23565
FS_ID:66545
EP_NO: N/A
Repair Type: Non-Urgent
EVAL Issue: Pipe Damage
Crossing Status: Found
UCIP Comments: 02/24/2021 The record has been upgraded from No Action Needed to Non-Urgent. DWR DMP has found integrity issues, LOF between 4 and 5. Crossing will be monitored until funding becomes available for rehabilitation. No permit was found authorizing this encroachment. CVFPB will need to review crossing to determine owner. The UCIP inspection was completed with GEI staff, B. Singh. (H. Dunn – GEI)
FIELD_STRUCT_DESC: 24-inch corrugated metal drainage pipe through the levee, 7 feet below the crown. Concrete U-shaped headwalls on both ends. Flap gate on the waterside (WS) end. Cobble grouted spillway across the berm. Cobble grouted apron on the landside (LS) end. [Additional Reference(s): DWR Levee Log, 1987. USACE San Joaquin O&M Manual 612.2, 1967, (HLM 7.75)].
FS Date: 2/24/2021

LS headwall at toe from crown.

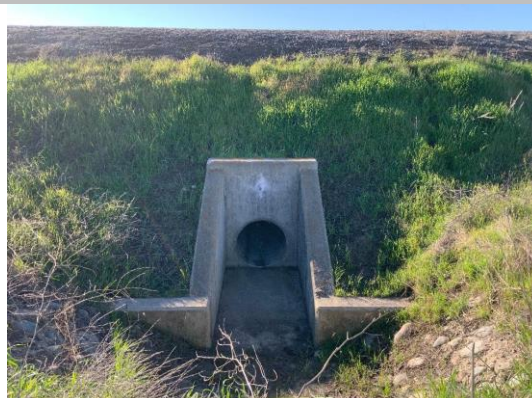
Photo 2 of 3 : UCIP_FA_2021_66545_91905.jpg

LS headwall at toe.

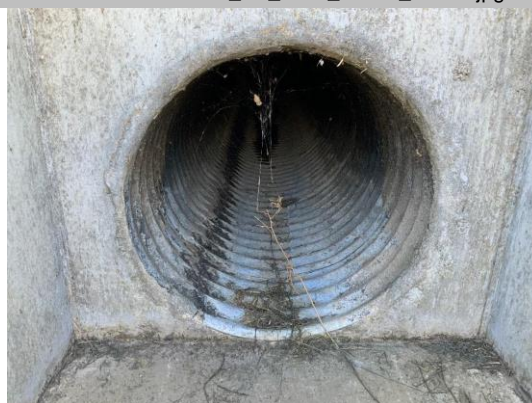
Photo 3 of 3 : UCIP_FA_2021_66545_91906.jpg

LS pipe.

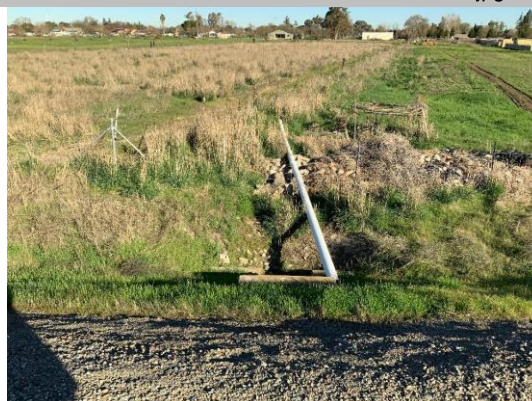
Photo 1 of 3 : UCIP_FA_2021_66546_91912.jpg

Comment Code						
Inspector Comment						
DS_ID:23566 FS_ID:66546 EP_NO: N/A Repair Type: Non-Urgent EVAL Issue: Pipe Damage Crossing Status: Found UCIP Comments: 02/24/2021 The record has been upgraded from No Action Needed to Non-Urgent. DWR DMP has found integrity issues, LOF between 4 and 5. Crossing will be monitored until funding becomes available for rehabilitation. No permit was found authorizing this encroachment. CVFPB will need to review crossing to determine owner. Small plastic pipe that was previously laying inside drainage pipe is now laying outside adjacent to headwall. The UCIP inspection was completed with GEI staff, B. Singh. (H. Dunn – GEI) FIELD_STRUCT_DESC: 24-inch corrugated metal storm drainage pipe through the levee, 7 feet below the crown. Concrete U-shaped headwalls on both ends. Flap gate on the waterside (WS) end. Cobble grouted spillway across the berm. Cobble grouted apron on the landside (LS) end. [Additional Reference(s): DWR Levee Log, 1987. USACE San Joaquin O&M Manual 612.2, 1967, (HLM 7.76) and 612 (addendum), February 1999, (HLM 7.78) (Station 410+54)]. FS Date: 2/24/2021

LS headwall at toe from crown.

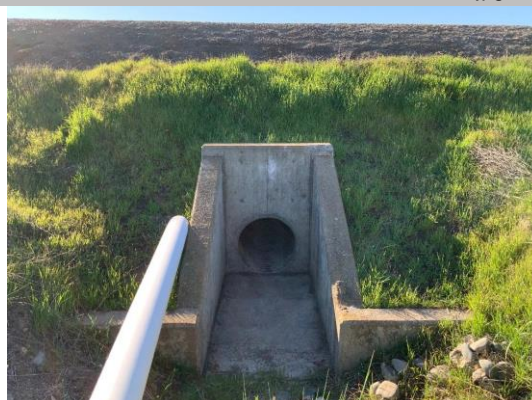
Photo 2 of 3 : UCIP_FA_2021_66546_91913.jpg

LS headwall at toe.
