**Flood Control Project Maintenance
Levee Inspections**

Maintenance Issue Types Only, Levee Inspection Report By Mile - Fall 2021

San Joaquin County Flood Control and Water Conservation District

Waterway	Bank	Unit Miles	Inspection Start/End	Inspector
Unit No. 01 Littlejohn Creek	Left	2.59	10/21/2021 10/21/2021	Alberto De Leon

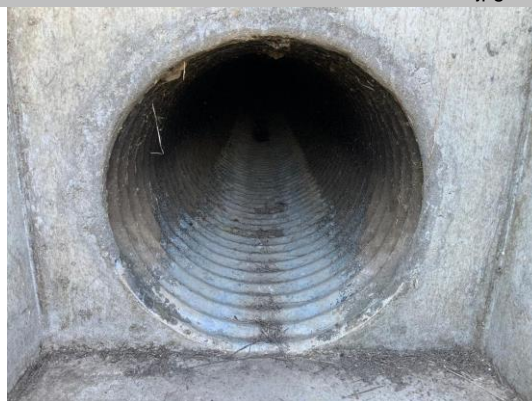
Photo 3 of 3 : UCIP_FA_2021_66546_91914.jpg

Comment Code						
Inspector Comment						
DS_ID:23566 FS_ID:66546 EP_NO: N/A Repair Type: Non-Urgent EVAL Issue: Pipe Damage Crossing Status: Found UCIP Comments: 02/24/2021 The record has been upgraded from No Action Needed to Non-Urgent. DWR DMP has found integrity issues, LOF between 4 and 5. Crossing will be monitored until funding becomes available for rehabilitation. No permit was found authorizing this encroachment. CVFPB will need to review crossing to determine owner. Small plastic pipe that was previously laying inside drainage pipe is now laying outside adjacent to headwall. The UCIP inspection was completed with GEI staff, B. Singh. (H. Dunn – GEI) FIELD_STRUCT_DESC: 24-inch corrugated metal storm drainage pipe through the levee, 7 feet below the crown. Concrete U-shaped headwalls on both ends. Flap gate on the waterside (WS) end. Cobble grouted spillway across the berm. Cobble grouted apron on the landside (LS) end. [Additional Reference(s): DWR Levee Log, 1987. USACE San Joaquin O&M Manual 612.2, 1967, (HLM 7.76) and 612 (addendum), February 1999, (HLM 7.78) (Station 410+54)]. FS Date: 2/24/2021

LS pipe.

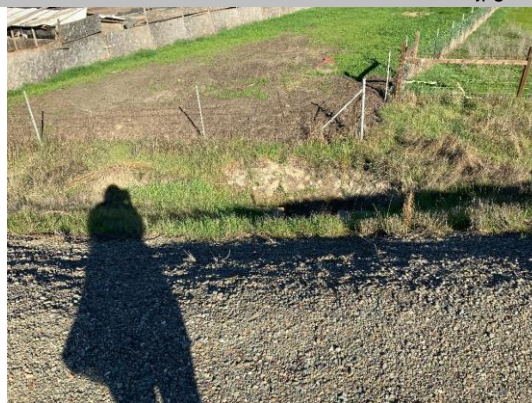
Photo 1 of 3 : UCIP_FA_2021_66547_91921.jpg

Comment Code						
Inspector Comment						
DS_ID:23567						
FS_ID:66547						
EP_NO: N/A						
Repair Type: Urgent						
EVAL Issue: Pipe Integrity						
Crossing Status: Found						
UCIP Comments: 02/24/2021 The record has been upgraded from No Action Needed to Urgent. Significant peeling of metal inside LS pipe. DWR DMP has found integrity issues, LOF between 5 and 6. Crossing will be monitored until funding becomes available to address the issues. No permit was found authorizing this encroachment. CVFPB will need to review crossing to determine owner. The UCIP inspection was completed with GEI staff, B. Singh. (H. Dunn – GEI)						
FIELD_STRUCT_DESC: 24-inch corrugated metal storm drainage pipe through the levee, 7 feet below the crown. Concrete U-shaped headwalls on both ends. Flap gate on the waterside (WS) end. Cobble grouted spillway across the berm. Cobble grouted apron on the landside (LS) end. [Additional Reference(s): DWR Levee Log, 1987. USACE San Joaquin O&M Manual 612.2, 1967, (HLM 7.99) and 612 (addendum), February 1999, (HLM 7.94) (Station 419+06)].

LS view: LS headwall at toe from crown.

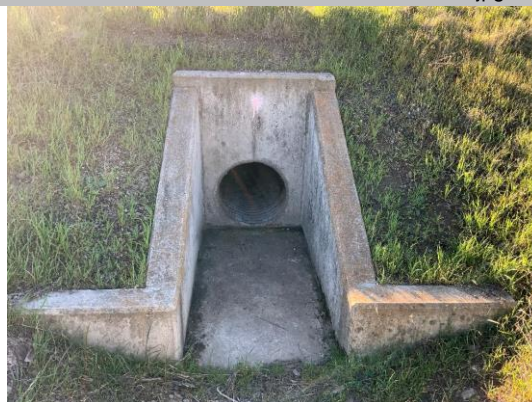
Photo 2 of 3 : UCIP_FA_2021_66547_91922.jpg

LS view: LS headwall at toe.

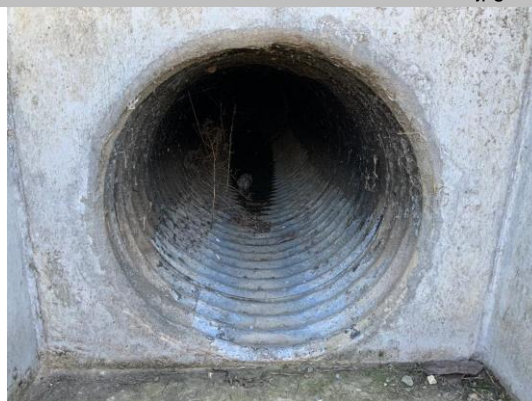
Photo 3 of 3 : UCIP_FA_2021_66547_91915.jpg

LS view: LS pipe.

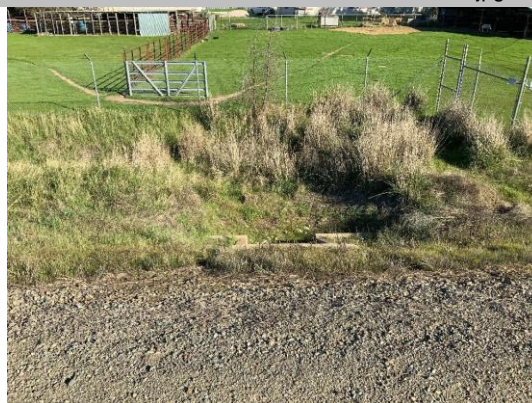
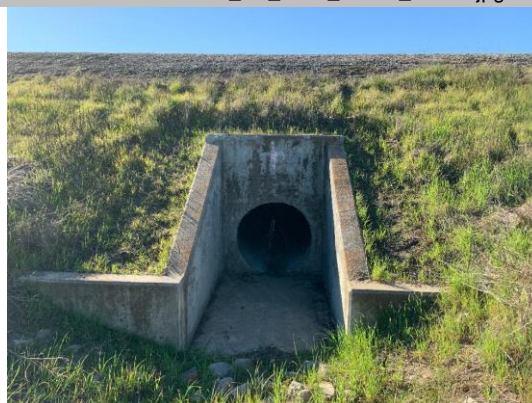
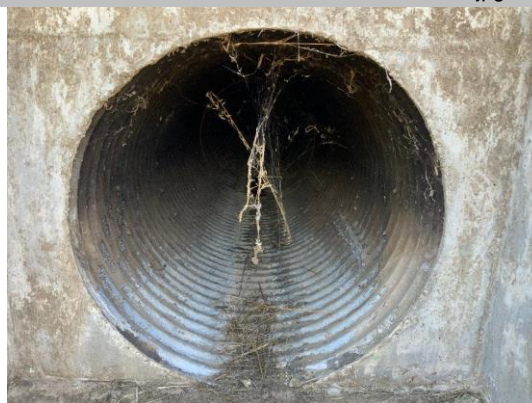
Comment Code						
Inspector Comment						
DS_ID:23568 FS_ID:66549 EP_NO: N/A Repair Type: Non-Urgent EVAL Issue: Pipe Damage Crossing Status: Found UCIP Comments: 02/24/2021 The record has been upgraded from No Action Needed to Non-Urgent. Significant peeling of metal inside LS pipe. DWR DMP has found integrity issues, LOF between 4 and 5. Crossing will be monitored until funding becomes available for rehabilitation. No permit was found authorizing this encroachment. CVFPB will need to review crossing to determine owner. The UCIP inspection was completed with GEI staff, B. Singh. (H. Dunn – GEI) FIELD_STRUCT_DESC: 36-inch corrugated metal drainage pipe through the levee, 8 feet below the crown. Concrete U-shaped headwalls on both ends. Flap gate on the waterside (WS) end. Cobble grouted spillway across the berm. Cobble grouted apron on the landside (LS) end. [Additional Reference(s): DWR Levee Log, 1987. USACE San Joaquin O&M Manual 612.2, 1967, (HLM 8.15)]. FS Date: 2/24/2021

LS view: LS headwall at toe from crown.

LS view: LS headwall at toe.

LS view: LS pipe.

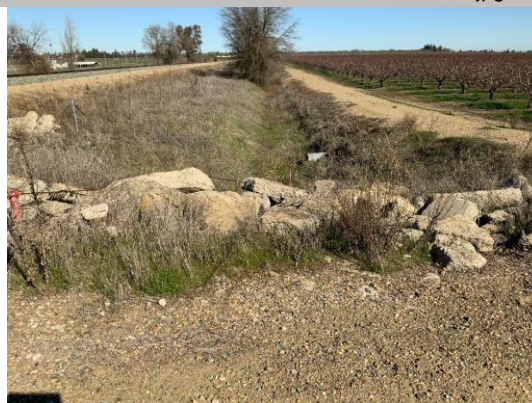
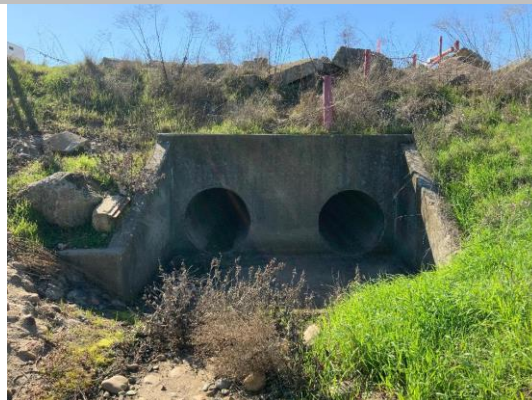
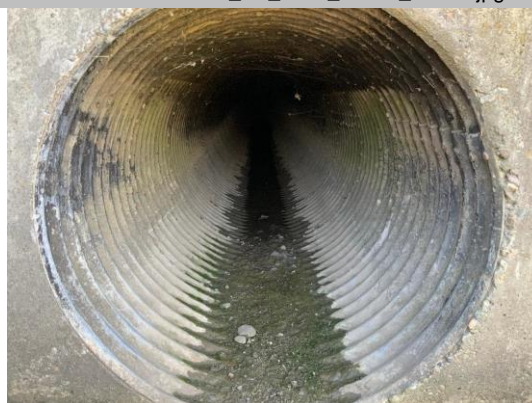
DS_ID:23569
FS_ID:64087
EP_NO: N/A
Repair Type: Non-Urgent
EVAL Issue: Unauthorized Encroachment, installed decades prior
Crossing Status: Found
UCIP Comments: 02/24/2021 The record has been upgraded from No Action Needed to Non-Urgent. DWR DMP has not found internal issues, LOF between 1 and 2. Recommend inspection in 5 years. No permit was found authorizing this encroachment. CVFPB will need to review crossing to determine owner. The UCIP inspection was completed with GEI staff, B. Singh. (H. Dunn – GEI)
FIELD_STRUCT_DESC: 1 of 2: 36-inch corrugated metal drainage pipe through the levee, 10.5 feet below the crown. Flap gate on the waterside (WS) end. Slide gate in 48-inch corrugated metal riser unit on the WS slope. Concrete U-shaped headwall on both ends. Cobble grouted spillway on bank. Cobble grouted apron on the landside (LS) end. [Additional Reference(s): DWR Levee Log, 1987. USACE San Joaquin O&M Manual 612.2, 1967, (HLM 8.28)].

LS view: LS headwall at toe from crown.

LS view: LS headwall at toe.

LS view: LS pipe.

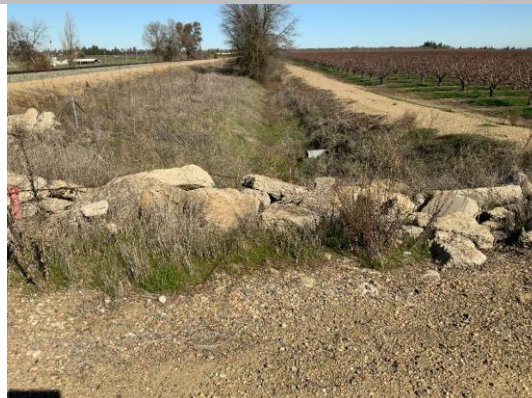
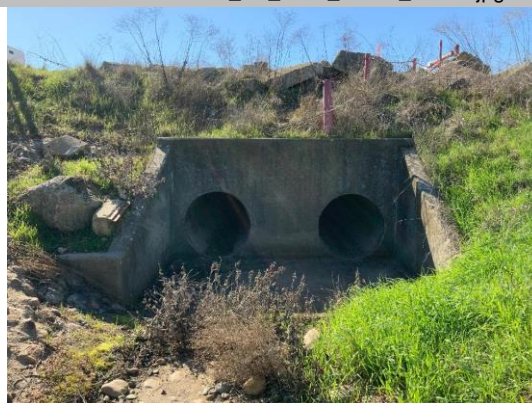
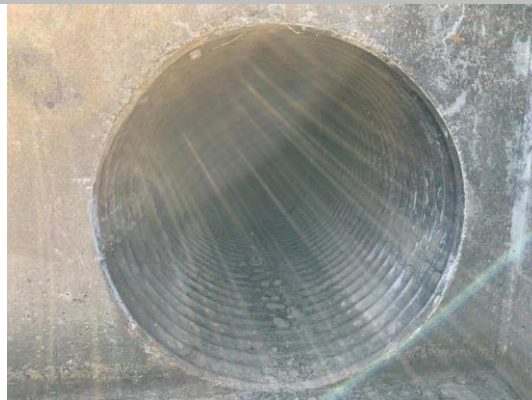
Comment Code						
Inspector Comment						
DS_ID:23682 FS_ID:64088 EP_NO: N/A Repair Type: Non-Urgent EVAL Issue: Unauthorized Encroachment, installed decades prior Crossing Status: Found UCIP Comments: 02/24/2021 The record has been upgraded from No Action Needed to Non-Urgent. DWR DMP has not found internal issues, LOF between 1 and 2. Recommend inspection in 5 years. No permit was found authorizing this encroachment. CVFPB will need to review crossing to determine owner. The UCIP inspection was completed with GEI staff, B. Singh. (H. Dunn – GEI) FIELD_STRUCT_DESC: 2 of 2: 36-inch corrugated metal drainage pipe through the levee, 10.5 feet below the crown. Flap gate on the waterside (WS) end. Slide gate in 48-inch corrugated metal riser unit on the WS slope. Concrete U-shaped headwall on both ends. Cobble grouted spillway on bank. Cobble grouted apron on the landside (LS) end. [Additional Reference(s): DWR Levee Log, 1987. USACE San Joaquin O&M Manual 612.2, 1967, (HLM 8.28)]. FS Date: 2/24/2021

LS headwall at toe from crown.

LS headwall at toe.

LS pipe.

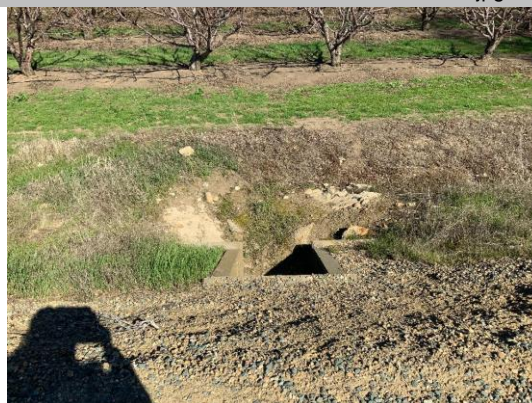
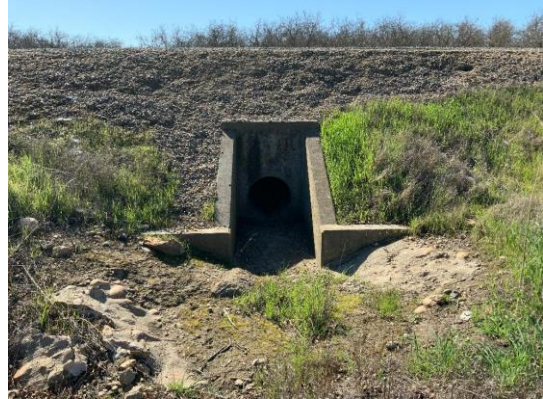
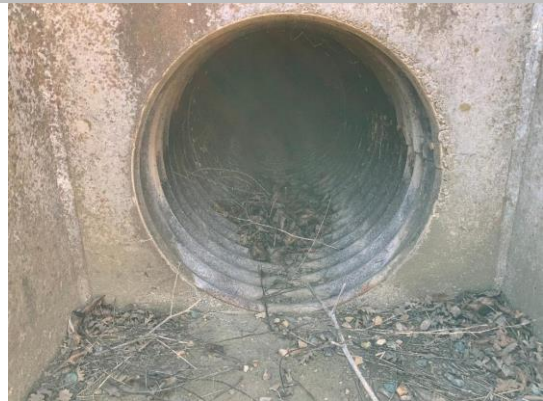
DS_ID:23570
FS_ID:66552
EP_NO: N/A
Repair Type: Non-Urgent
EVAL Issue: Pipe Damage
Crossing Status: Found
UCIP Comments: 02/24/2021 The record has been upgraded from No Action Needed to Non-Urgent. DWR DMP has found integrity issues, LOF between 4 and 5. Crossing will be monitored until funding becomes available for rehabilitation. No permit was found authorizing this encroachment. CVFPB will need to review crossing to determine owner. The UCIP inspection was completed with GEI staff, B. Singh. (H. Dunn – GEI)
FIELD_STRUCT_DESC: 24-inch corrugated metal storm drainage pipe through the levee, 6.5 feet below the crown. Flap gate on the waterside (WS) end. Concrete U-shaped headwalls on both ends. Cobble grouted spillway across the berm. Cobble grouted apron on the landside (LS) end. [Additional Reference(s): DWR Levee Log, 1987. USACE San Joaquin O&M Manual 612.2, 1967, (HLM 8.49) and 612 (addendum), February 1999, (HLM 8.41) (Station 444+00)].

LS headwall at toe from crown.

LS headwall at toe.

LS pipe.

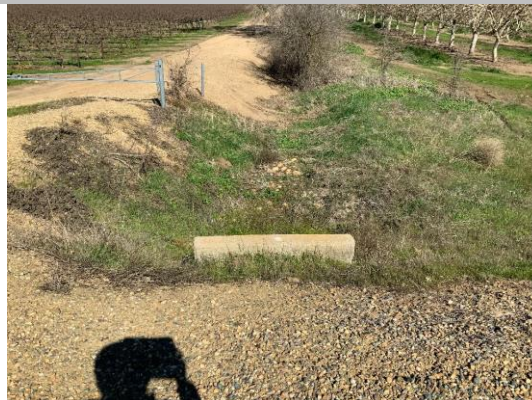
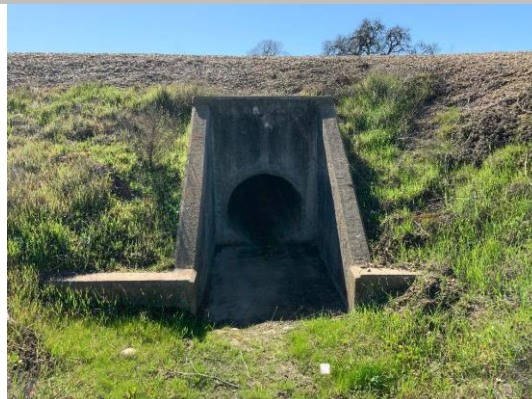
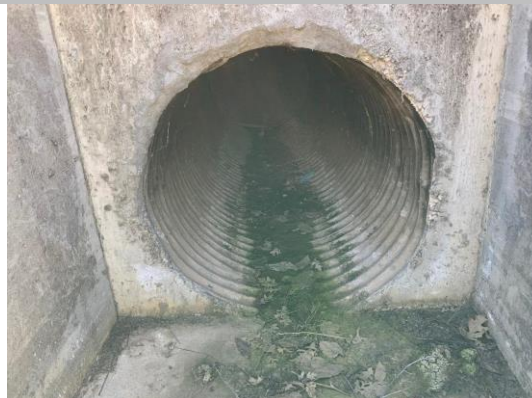
Comment Code						
Inspector Comment						
DS_ID:23572 FS_ID:66876 EP_NO: N/A Repair Type: Urgent EVAL Issue: Pipe Integrity Crossing Status: Found UCIP Comments: 02/24/2021 The record has been upgraded from Non-Urgent to Urgent. Significant peeling of metal and gap inside of LS pipe. DWR DMP has found integrity issues, LOF between 5 and 6. Crossing will be monitored until funding becomes available to address the issues. No permit was found authorizing this encroachment. CVFPB will need to review crossing to determine owner. The UCIP inspection was completed with GEI staff, B. Singh. (H. Dunn – GEI) 05/14/2014 A gap at the joint between pipe sections was noted inside pipe at LS toe. This may indicate a need for further maintenance. (W. Wylie -DWR UCIP) FIELD_STRUCT_DESC: 36-inch corrugated metal drainage pipe through the levee, 7 feet below the crown. Flap gate on the waterside (WS) end. Concrete U-shaped headwalls on both ends. Cobble grouted spillway across the berm. Cobble grouted apron on the landside (LS) end. [Additional Reference(s): DWR Levee Log, 1987. USACE San Joaquin O&M Manual 612.2, 1967, (HLM 8.77)]. FS Date: 2/24/2021

LS view: LS headwall at toe from crown.

LS view: LS headwall at toe.

LS view: LS pipe.

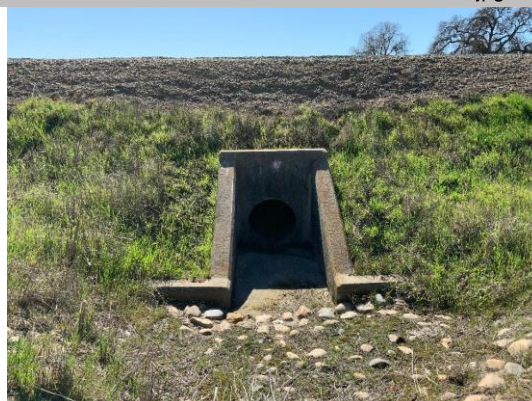
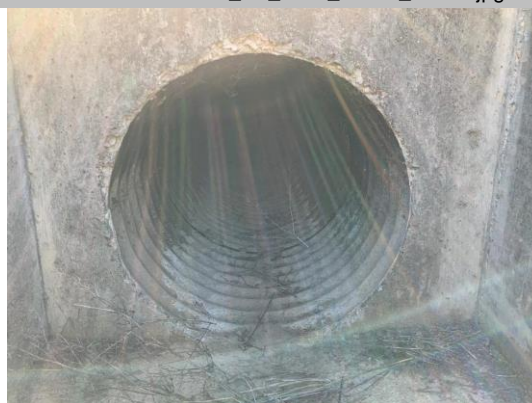
DS_ID:23573
FS_ID:66558
EP_NO: N/A
Repair Type: Non-Urgent
EVAL Issue: Pipe Damage
Crossing Status: Found
UCIP Comments: 02/24/2021 Pipe status is still Non-Urgent. Significant peeling of metal inside LS pipe in multiple spots. DWR DMP has found integrity issues, LOF between 4 and 5. Crossing will be monitored until funding becomes available for rehabilitation. No permit was found authorizing this encroachment. No permit was found authorizing this encroachment. CVFPB will need to review crossing to determine owner. The UCIP inspection was completed with GEI staff, B. Singh. (H. Dunn – GEI)
FIELD_STRUCT_DESC: 24-inch corrugated metal drainage pipe through the levee, 6.5 feet below the crown. Flap gate on the waterside (WS) end. Concrete U-shaped headwalls on both ends. Cobble grouted spillway across the berm. Cobble grouted apron on the landside (LS) end. [Additional Reference(s): DWR Levee Log, 1987. USACE San Joaquin O&M Manual 612.2, 1967, (HLM 8.78)].

LS view: LS headwall at toe from crown.

LS view: LS headwall at toe.

LS view: LS pipe.

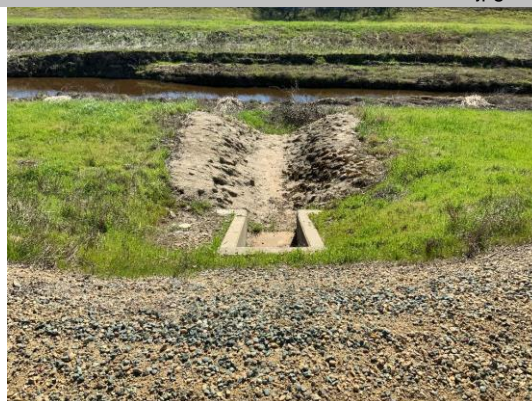
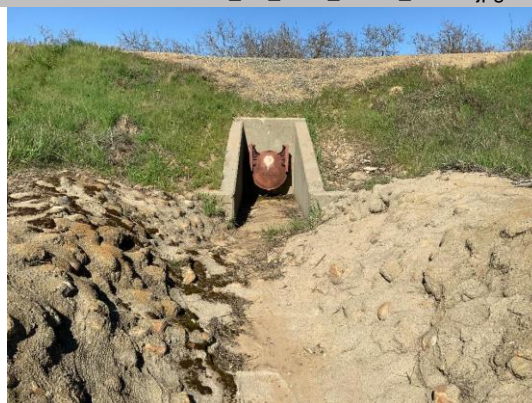
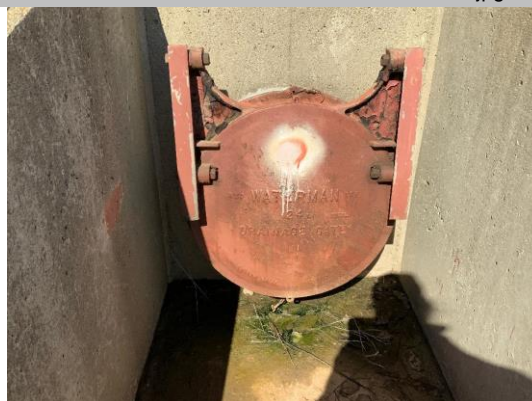
Comment Code						
Inspector Comment						
DS_ID:23574 FS_ID:66559 EP_NO: N/A Repair Type: Non-Urgent EVAL Issue: Pipe Damage Crossing Status: Found UCIP Comments: 02/24/2021 The record has been upgraded from No Action Needed to Non-Urgent. DWR DMP has found integrity issues, LOF between 4 and 5. Crossing will be monitored until funding becomes available for rehabilitation. No permit was found authorizing this encroachment. CVFPB will need to review crossing to determine owner. The UCIP inspection was completed with GEI staff, B. Singh. (H. Dunn – GEI) FIELD_STRUCT_DESC: 24-inch corrugated metal storm drainage pipe through the levee, 7 feet below the crown. Flap gate on the waterside (WS) end. Concrete U-shaped headwalls on both ends. Cobble spillway across the berm. [Additional Reference(s): DWR Levee Log, 1987. USACE San Joaquin O&M Manual 612.2, 1967, (HLM 8.97) and 612 (addendum), February 1999, (HLM 8.90) (Station 469+82)]. FS Date: 2/24/2021

WS view: WS headwall at toe.

WS view: WS headwall and flapgate at toe.

WS view: WS flapgate.

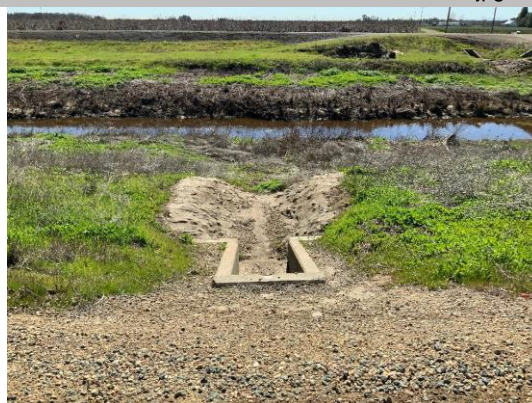
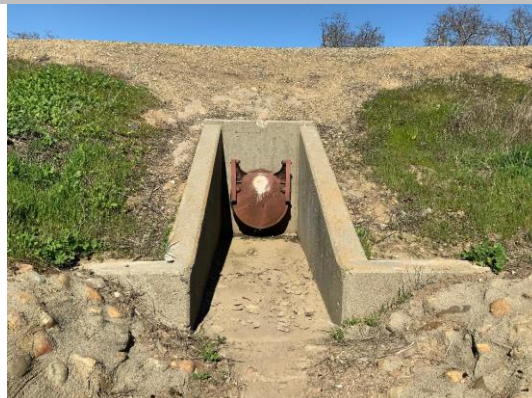
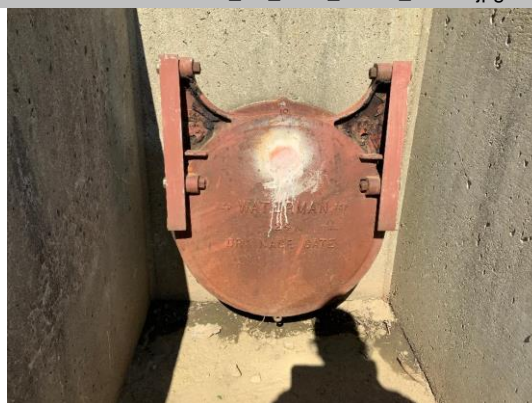
DS_ID:23576
 FS_ID:66560
 EP_NO: N/A
 Repair Type: Non-Urgent
 EVAL Issue: Pipe Damage
 Crossing Status: Found
 UCIP Comments: 02/24/2021 The record has been upgraded from No Action Needed to Non-Urgent. DWR DMP has found integrity issues, LOF between 4 and 5. Crossing will be monitored until funding becomes available for rehabilitation. Minor flaking off of concrete on the inside edge of LS headwall. No permit was found authorizing this encroachment. CVFPB will need to review crossing to determine owner. The UCIP inspection was completed with GEI staff, B. Singh. (H. Dunn – GEI)
 FIELD_STRUCT_DESC: 24-inch corrugated metal storm drainage pipe through the levee, 6.5 feet below the crown. Flap gate on the waterside (WS) end. Concrete U-shaped headwalls on both ends. Cobble grouted spillway across the berm. Cobble grouted apron on the landside (LS) end. [Additional Reference(s): DWR Levee Log, 1987. USACE San Joaquin O&M Manual 612.2, 1967, (HLM 9.17) and 612 (addendum), February 1999, (HLM 9.17) (Station 484+30)].

WS view: WS headwall at toe from crown.

WS view: WS headwall and flapgate at toe.

WS view: WS flapgate.

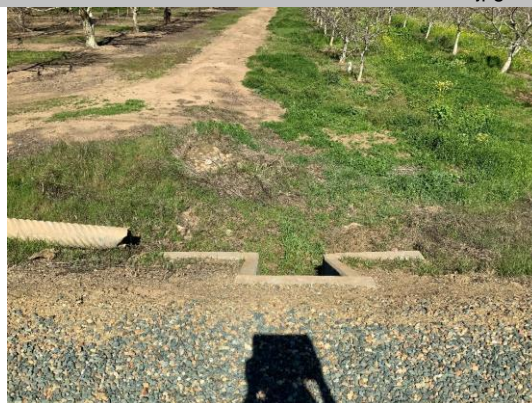
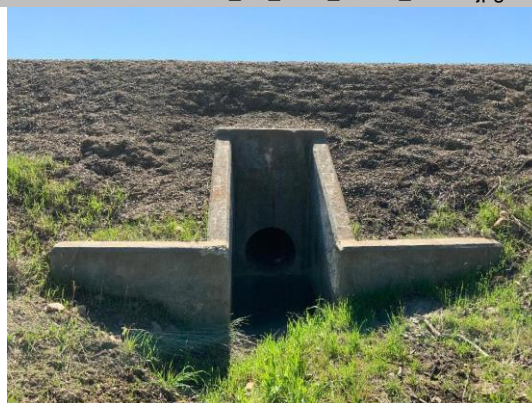
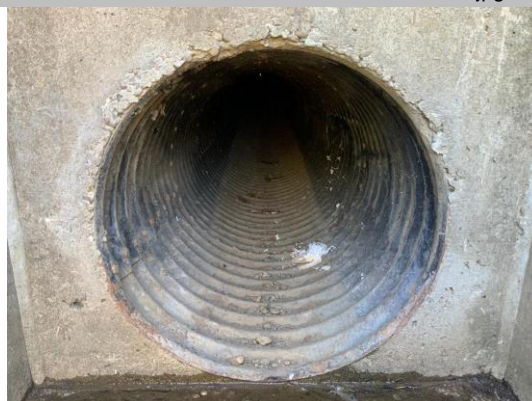
Comment Code						
Inspector Comment						
DS_ID:23578 FS_ID:64117 EP_NO: N/A Repair Type: Non-Urgent EVAL Issue: Unauthorized Encroachment, installed decades prior Crossing Status: Found UCIP Comments: 02/24/2021 The record has been upgraded from No Action Needed to Non-Urgent. DWR DMP has not found internal issues, LOF between 1 and 2. Recommend inspection in 5 years. No permit was found authorizing this encroachment. CVFPB will need to review crossing to determine owner. The UCIP inspection was completed with GEI staff, B. Singh. (H. Dunn – GEI) FIELD_STRUCT_DESC: 24-inch corrugated metal drainage pipe through the levee, 8 feet below the crown. Flap gate on the waterside (WS) end. Concrete U-shaped headwall on both ends. Cobble grouted spillway across the berm. Cobble grouted apron on the landside (LS) end. [Additional Reference(s): DWR Levee Log, 1987. USACE San Joaquin O&M Manual 612.2, 1967, (HLM 9.41) and 612 (addendum), February 1999, (HLM 9.37) (Station 494+50)]. FS Date: 2/24/2021

LS view: LS headwall at toe from crown.

LS view: LS headwall at toe.

LS view: LS pipe.

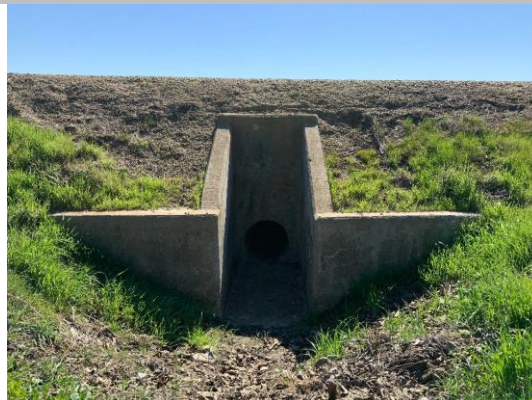
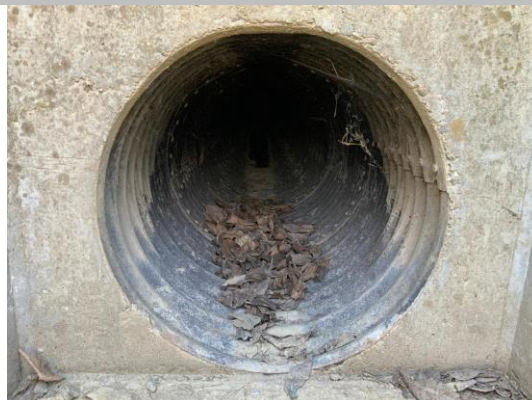
DS_ID:23580
 FS_ID:66564
 EP_NO: N/A
 Repair Type: Non-Urgent
 EVAL Issue: Pipe Damage
 Crossing Status: Found
 UCIP Comments: 02/24/2021 The record has been upgraded from No Action Needed to Non-Urgent. DWR DMP has found integrity issues, LOF between 4 and 5. Crossing will be monitored until funding becomes available for rehabilitation. No permit was found authorizing this encroachment. CVFPB will need to review crossing to determine owner. The UCIP inspection was completed with GEI staff, B. Singh. (H. Dunn – GEI)
 FIELD_STRUCT_DESC: 24-inch corrugated metal storm drainage pipe through the levee, 6.5 feet below the crown. Flap gate on the waterside (WS) end. Concrete U-shaped headwall on both ends. Cobble grouted spillway and apron. [Additional Reference(s): DWR Levee Log, 1987. USACE San Joaquin O&M Manual 612.2, 1967, (HLM 9.56) and 612 (addendum), February 1999, (HLM 9.56) (Station 504+71)].

LS headwall at toe from crown.

LS headwall at toe.

LS pipe.

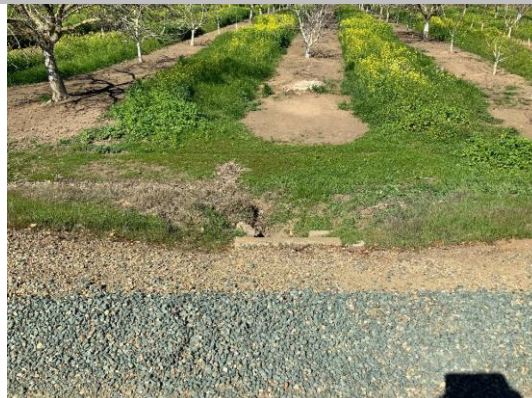
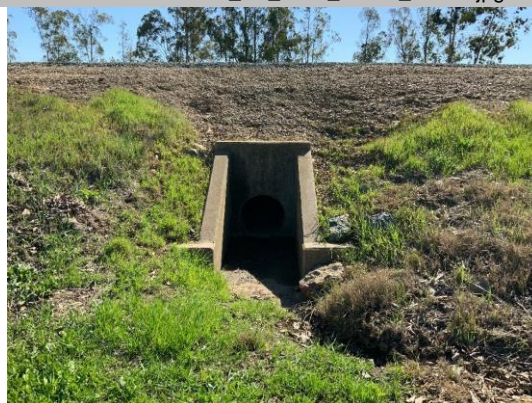
Comment Code						
Inspector Comment						
DS_ID:23582 FS_ID:66568 EP_NO: N/A Repair Type: Non-Urgent EVAL Issue: Pipe Damage Crossing Status: Found UCIP Comments: 02/24/2021 The record has been upgraded from No Action Needed to Non-Urgent. DWR DMP has found integrity issues, LOF between 4 and 5. Crossing will be monitored until funding becomes available for rehabilitation. No permit was found authorizing this encroachment. CVFPB will need to review crossing to determine owner. The UCIP inspection was completed with GEI staff, B. Singh. (H. Dunn – GEI) FIELD_STRUCT_DESC: 24-inch corrugated metal drainage pipe through the levee, 7.5 feet below the crown. Flap gate on the waterside (WS) end. Concrete U-shaped headwalls on both ends. Cobble grouted spillway across the berm. Cobble grouted apron on the WS end. [Additional Reference(s): DWR Levee Log, 1987. USACE San Joaquin O&M Manual 612.2, 1967, (HLM 9.91)]. FS Date: 2/24/2021

LS view: LS headwall at toe from crown.

LS view: LS headwall at toe.

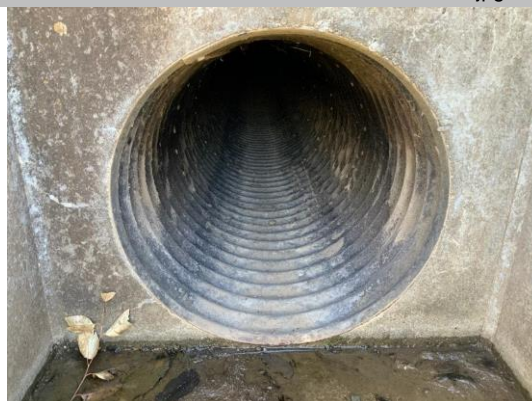
Photo 3 of 3 : UCIP_FA_2021_66568_92060.jpg

LS view: LS pipe.

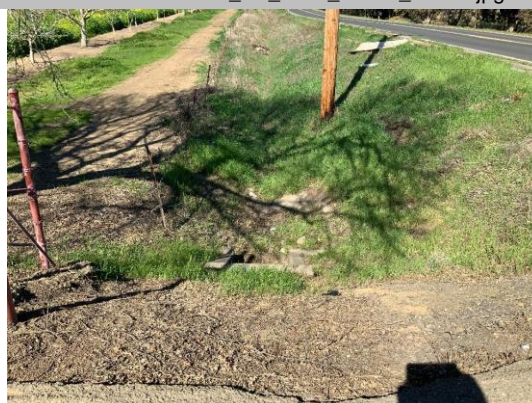
Photo 1 of 3 : UCIP_FA_2021_66569_92065.jpg

UCIP Comments: 02/24/2021 The record has been upgraded from No Action Needed to Non-Urgent. DWR DMP has found integrity issues, LOF between 4 and 5. Crossing will be monitored until funding becomes available for rehabilitation. No permit was found authorizing this encroachment. CVFPB will need to review crossing to determine owner. The UCIP inspection was completed with GEI staff, B. Singh. (H. Dunn – GEI)

LS view: LS headwall at toe from crown.

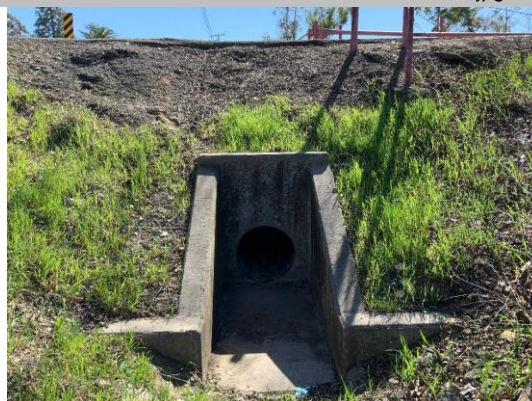
Photo 2 of 3 : UCIP_FA_2021_66569_92066.jpg

LS view: LS headwall at toe.

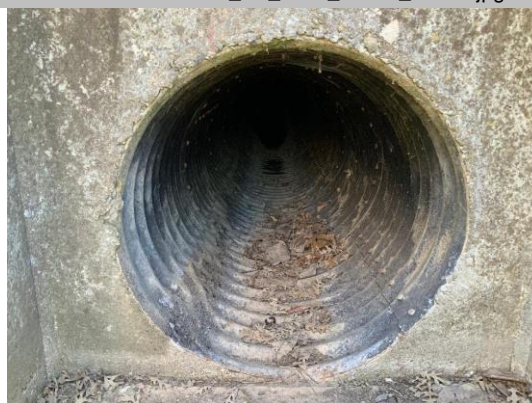
Photo 3 of 3 : UCIP_FA_2021_66569_92067.jpg

LS view: LS pipe.

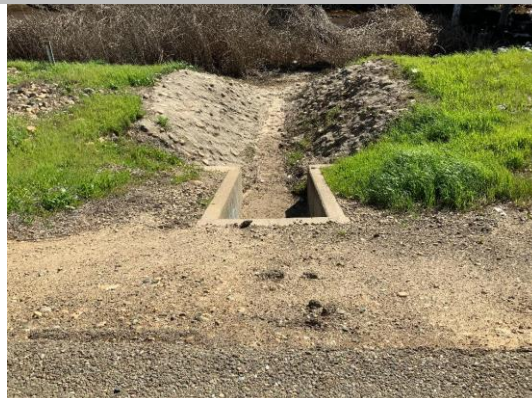
Photo 1 of 3 : UCIP_FA_2021_66571_92077.jpg

Comment Code						
Inspector Comment						
DS_ID:23584 FS_ID:66571 EP_NO: N/A Repair Type: Non-Urgent EVAL Issue: Pipe Damage Crossing Status: Found UCIP Comments: 02/24/2021 The record has been upgraded from No Action Needed to Non-Urgent. DWR DMP has found integrity issues, LOF between 4 and 5. Crossing will be monitored until funding becomes available for rehabilitation. No permit was found authorizing this encroachment. CVFPB will need to review crossing to determine owner. The UCIP inspection was completed with GEI staff, B. Singh. (H. Dunn – GEI) FIELD_STRUCT_DESC: 36-inch corrugated metal drainage pipe through the levee, 6 feet below the crown. Flap gate on the waterside (WS) end. Concrete U-shaped headwalls on both ends. Cobble grouted spillway across the berm. Cobble grouted apron on the landside (LS) end. [Additional Reference(s): DWR Levee Log, 1987. USACE San Joaquin O&M Manual 612.2, 1967, (HLM 10.11)]. FS Date: 2/24/2021

WS view: WS headwall at toe from crown.

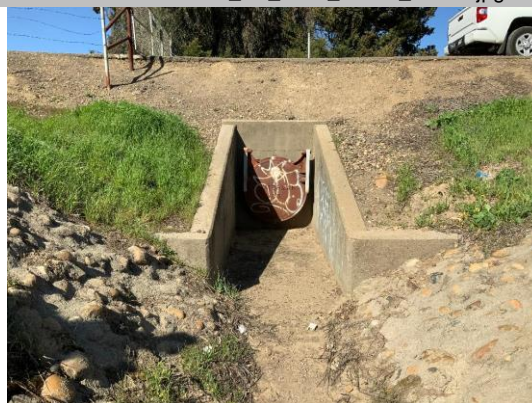
Photo 2 of 3 : UCIP_FA_2021_66571_92078.jpg

WS view: WS headwall and flapgate at toe.

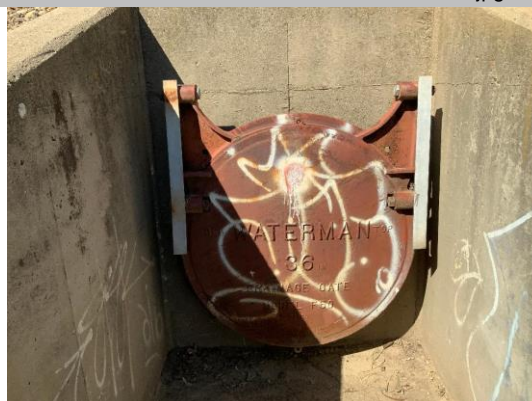
Photo 3 of 3 : UCIP_FA_2021_66571_92079.jpg

WS view: WS flapgate.

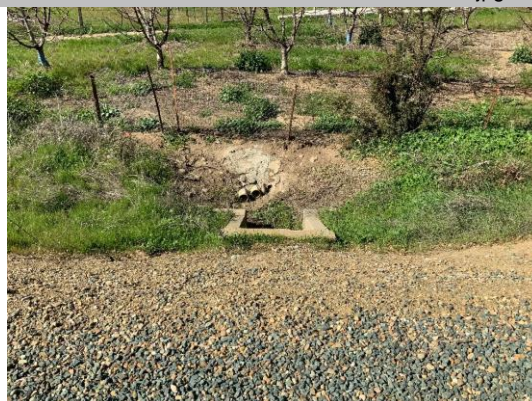
Photo 1 of 3 : UCIP_FA_2021_64127_92096.jpg

Comment Code						
Inspector Comment						
DS_ID:23585 FS_ID:64127 EP_NO: N/A Repair Type: Non-Urgent EVAL Issue: Unauthorized Encroachment, installed decades prior Crossing Status: Found UCIP Comments: 02/24/2021 Pipe status is still Non-Urgent. DWR DMP has not found internal issues, LOF between 1 and 2. Recommend inspection in 5 years. No permit was found authorizing this encroachment. CVFPB will need to review crossing to determine owner. The UCIP inspection was completed with GEI staff, B. Singh. (H. Dunn – GEI) FIELD_STRUCT_DESC: 24-inch corrugated metal storm drainage pipe through the levee, 7.5 feet below the crown. Flap gate on the waterside (WS) end. Concrete U-shaped headwalls on both ends. Cobble grouted spillway across the berm. [Additional Reference(s): DWR Levee Log, 1987. USACE San Joaquin O&M Manual 612.2, 1967, (HLM 10.45) and 612 (addendum), February 1999, (HLM 10.46) (Station 552+25)]. FS Date: 2/24/2021

LS view: LS headwall at toe from crown.

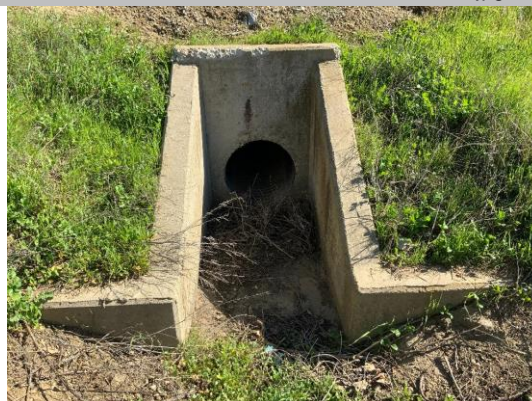
Photo 2 of 3 : UCIP_FA_2021_64127_92097.jpg

LS view: LS headwall at toe.

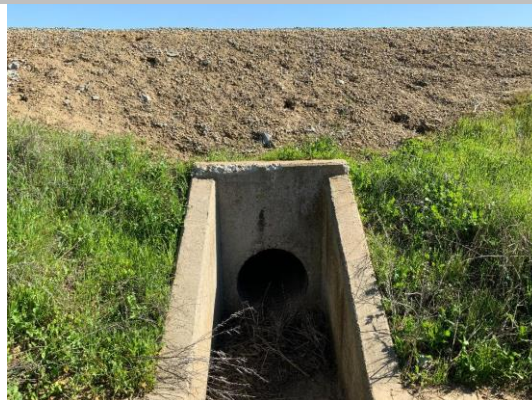
Photo 3 of 3 : UCIP_FA_2021_64127_92098.jpg

LS view: LS headwall at toe.

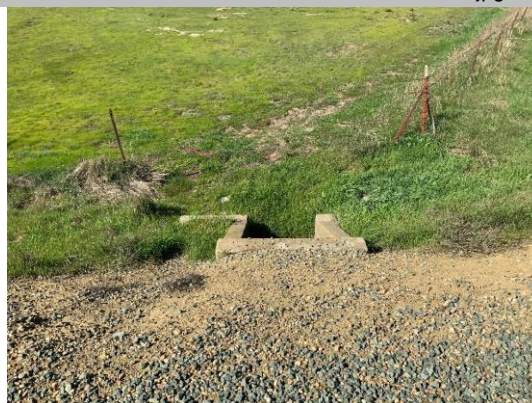
Photo 1 of 3 : UCIP_FA_2021_66650_92108.jpg

DS_ID:23586
FS_ID:66650
EP_NO: N/A
Repair Type: Non-Urgent
EVAL Issue: Unauthorized Encroachment, installed decades prior
Crossing Status: Found
UCIP Comments: 02/24/2021 The record has been upgraded from No Action Needed to Non-Urgent. DWR DMP has not found internal issues, LOF between 1 and 2. Recommend inspection in 5 years. No permit was found authorizing this encroachment. CVFPB will need to review crossing to determine owner. The UCIP inspection was completed with GEI staff, B. Singh. (H. Dunn – GEI)
FIELD_STRUCT_DESC: 24-inch corrugated metal drainage pipe through the levee, 6 feet below the crown. Flap gate on the waterside (WS) end. Concrete U-shaped headwalls on both ends. Cobble grouted spillway across the berm. Cobble grouted apron on the landside (LS) end. [Additional Reference(s): USACE San Joaquin O&M Manual 612.2, 1967, (HLM 10.62)].
FS Date: 2/24/2021

LS view: LS headwall at toe from crown.

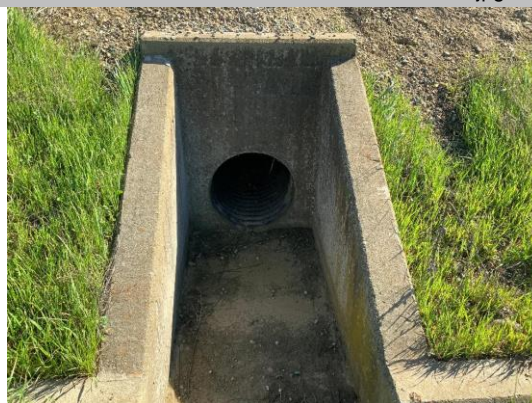
Photo 2 of 3 : UCIP_FA_2021_66650_92109.jpg

LS view: LS headwall at toe.

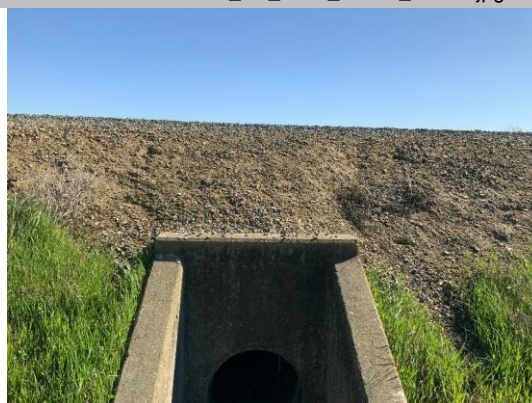
Photo 3 of 3 : UCIP_FA_2021_66650_92110.jpg

LS view: LS headwall at toe.

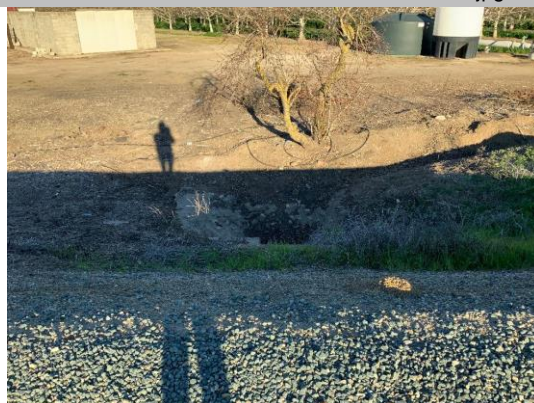
Photo 1 of 3 : UCIP_FA_2021_64132_92115.jpg

Comment Code						
Inspector Comment						
DS_ID:23646 FS_ID:64132 EP_NO: N/A Repair Type: Non-Urgent EVAL Issue: Unauthorized Encroachment, installed decades prior Crossing Status: Found UCIP Comments: 02/25/2021 The record has been upgraded from No Action Needed to Non-Urgent. DWR DMP has not found internal issues, LOF between 1 and 2. Recommend inspection in 5 years. WS flapgate partially covered by vegetation. No permit was found authorizing this encroachment. CVFPB will need to review crossing to determine owner. The UCIP inspection was completed with LMA representative, M. Mccoy. (H. Dunn – GEI) FIELD_STRUCT_DESC: 24-inch corrugated metal storm drainage pipe through the levee, 7.5 feet below the crown. Flap gate on the waterside (WS). Concrete U-shaped headwall on both ends. [Additional Reference(s): DWR Levee Log, 1987. USACE San Joaquin O&M Manual 612.2, 1967, (HLM 10.91) and 612 (addendum), February 1999, (HLM 10.80) (Station 570+48)]. FS Date: 2/25/2021

LS view: LS headwall at toe from crown.

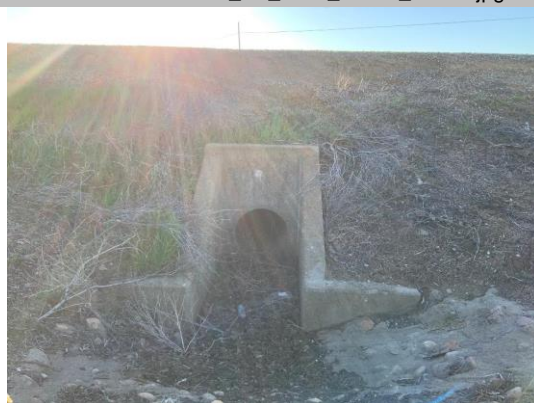
Photo 2 of 3 : UCIP_FA_2021_64132_92116.jpg

LS view: LS headwall at toe.

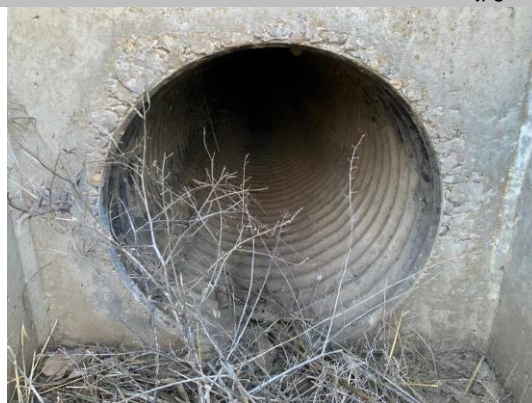
Photo 3 of 3 : UCIP_FA_2021_64132_92117.jpg

LS view: LS pipe.

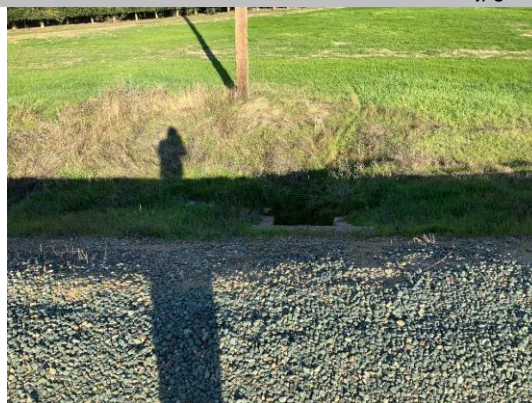
Photo 1 of 3 : UCIP_FA_2021_66652_92127.jpg

DS_ID:23587
 FS_ID:66652
 EP_NO: N/A
 Repair Type: Non-Urgent
 EVAL Issue: Unauthorized Encroachment, installed decades prior
 Crossing Status: Found
 UCIP Comments: 02/25/2021 Pipe status is still Non-Urgent. DWR DMP has not found internal issues, LOF between 1 and 2. Recommend inspection in 5 years. No permit was found authorizing this encroachment. CVFPB will need to review crossing to determine owner. The UCIP inspection was completed with LMA representative, M. McCoy. (H. Dunn – GEI) 05/14/2014 Silt buildup in pipe at LS toe. (W. Wylie - DWR UCIP)
 FIELD_STRUCT_DESC: 24-inch corrugated metal drainage pipe through the levee, 6.5 feet below the crown. Flap gate on the waterside (WS) end. Concrete U-shaped headwall on both ends. Cobble grouted spillway across the berm. Cobble grouted apron on the WS end.
 [Additional Reference(s): DWR Levee Log, 1987. USACE San Joaquin O&M Manual 612.2, 1967, (HLM 11.13)].

LS view: LS headwall at toe from crown.

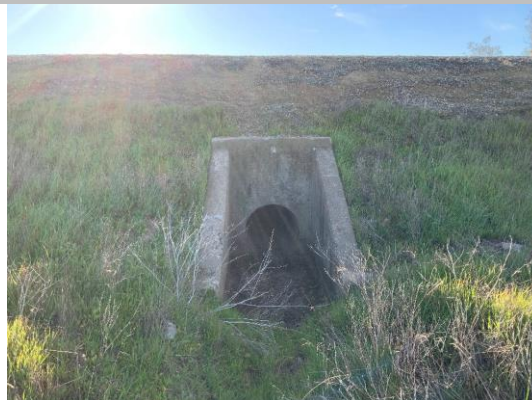
Photo 2 of 3 : UCIP_FA_2021_66652_92128.jpg

LS view: LS headwall at toe.

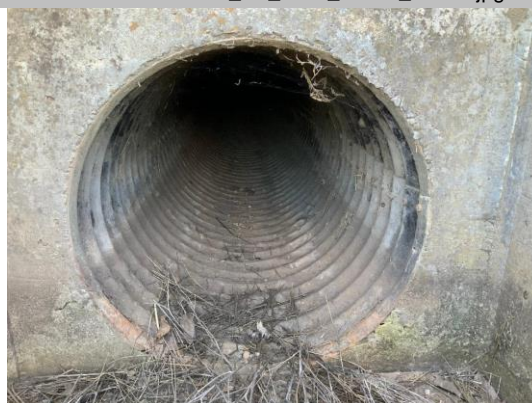
Photo 3 of 3 : UCIP_FA_2021_66652_92129.jpg

LS view: LS pipe.

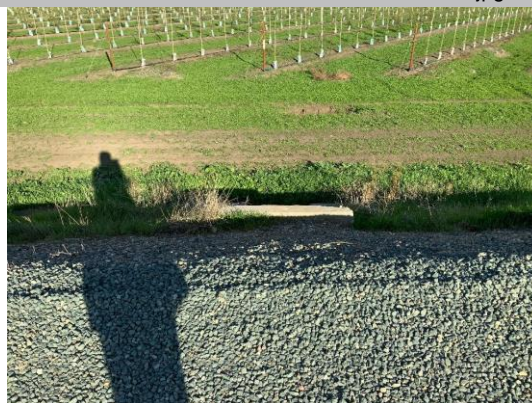
Photo 1 of 3 : UCIP_FA_2021_64134_92134.jpg

Comment Code					
Inspector Comment					
DS_ID:23588 FS_ID:64134 EP_NO: N/A Repair Type: Non-Urgent EVAL Issue: Unauthorized Encroachment, installed decades prior Crossing Status: Found UCIP Comments: 02/25/2021 The record has been upgraded from No Action Needed to Non-Urgent. DWR DMP has not found internal issues, LOF between 1 and 2. Recommend inspection in 5 years. No permit was found authorizing this encroachment. CVFPB will need to review crossing to determine owner. The UCIP inspection was completed with LMA representative, M. Mccoy. (H. Dunn – GEI) FIELD_STRUCT_DESC: 24-inch corrugated metal storm drainage pipe through the levee, 6.5 feet below the crown. Flap gate on the waterside (WS) end. Concrete U-shaped headwalls on both ends. Cobble grouted spillway across the berm. Cobble grouted apron on the landside (LS) end. [Additional Reference(s): DWR Levee Log, 1987. USACE San Joaquin O&M Manual 612.2, 1967, (HLM 11.30) and 612 (addendum), February 1999, (HLM 11.26) (Station 594+46)]. FS Date: 2/25/2021

LS headwall at toe from crown.

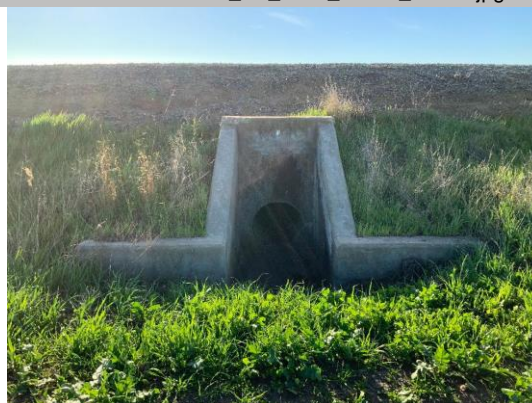
Photo 2 of 3 : UCIP_FA_2021_64134_92135.jpg

LS headwall at toe.

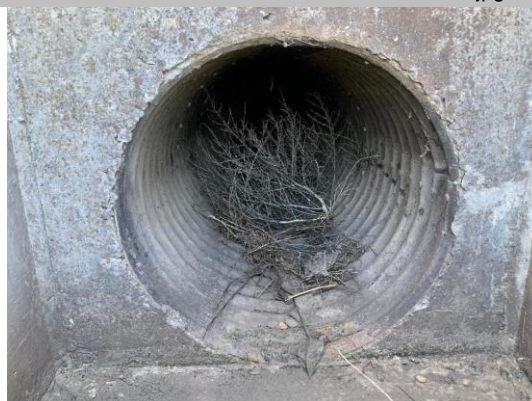
Photo 3 of 3 : UCIP_FA_2021_64134_92136.jpg

LS pipe, minor vegetation inside pipe.

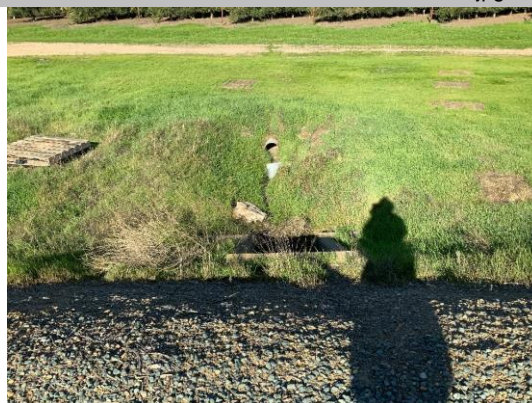
Photo 1 of 3 : UCIP_FA_2021_64138_92218.jpg

Comment Code						
Inspector Comment						
DS_ID:23590 FS_ID:64138 EP_NO: N/A Repair Type: Non-Urgent EVAL Issue: Unauthorized Encroachment, installed decades prior Crossing Status: Found UCIP Comments: 02/25/2021 The record has been upgraded from No Action Needed to Non-Urgent. DWR DMP has not found internal issues, LOF between 1 and 2. Recommend inspection in 5 years. No permit was found authorizing this encroachment. CVFPB will need to review crossing to determine owner. The UCIP inspection was completed with LMA representative, M. Mccoy. (H. Dunn – GEI) FIELD_STRUCT_DESC: 24-inch corrugated metal drainage pipe through the levee, 7.5 feet below the crown. Flap gate on the waterside (WS) end. Concrete U-shaped headwalls on both ends. Cobble grouted spillway across the berm. Cobble grouted apron on the landside (LS) end. [Additional Reference(s): DWR Levee Log, 1987. USACE San Joaquin O&M Manual 612.2, 1967, (HLM 11.78)]. FS Date: 2/25/2021

LS view: LS headwall at toe from crown.

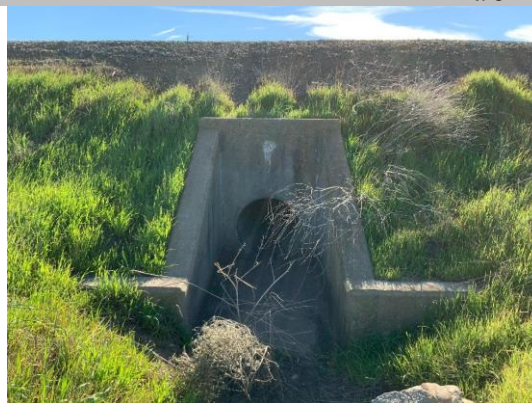
Photo 2 of 3 : UCIP_FA_2021_64138_92219.jpg

LS view: LS headwall at toe.

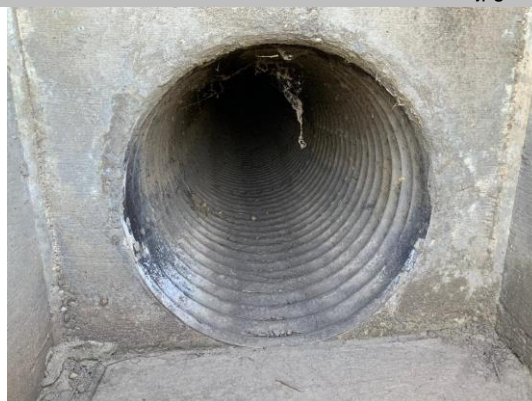
Photo 3 of 3 : UCIP_FA_2021_64138_92220.jpg

LS view: LS pipe.

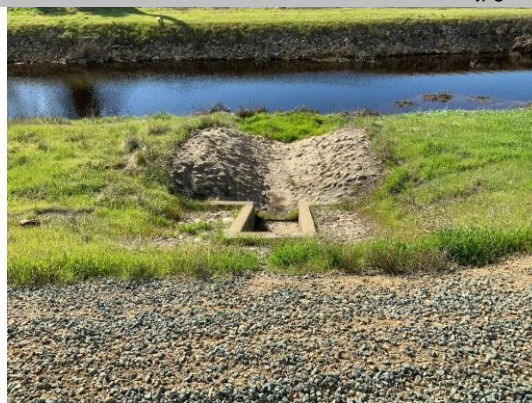
Photo 1 of 3 : UCIP_FA_2021_66882_92239.jpg

DS_ID:23593
FS_ID:66882
EP_NO: N/A
Repair Type: Non-Urgent
EVAL Issue: Unauthorized Encroachment, installed decades prior
Crossing Status: Found
UCIP Comments: 02/25/2021 Pipe status is still Non-Urgent. DWR DMP has not found internal issues, LOF between 1 and 2. Recommend inspection in 5 years. No permit was found authorizing this encroachment. CVFPB will need to review crossing to determine owner. The UCIP inspection was completed with LMA representative, M. McCoy. (H. Dunn – GEI) 05/14/2014 Some rocky debris buildup inside pipe on LS toe. (W. Wylie - DWR UCIP)
FIELD_STRUCT_DESC: 24-inch corrugated metal drainage pipe through the levee, 8.5 feet below the crown. Flap gate on the waterside (WS) end. Concrete U-shaped headwalls on both ends. Cobble grouted spillway across the berm. Cobble grouted apron on the landside (LS) end. [Additional Reference(s): DWR Levee Log, 1987. USACE San Joaquin O&M Manual 612.2, 1967, (HLM 12.30)].

WS headwall at toe from crown.

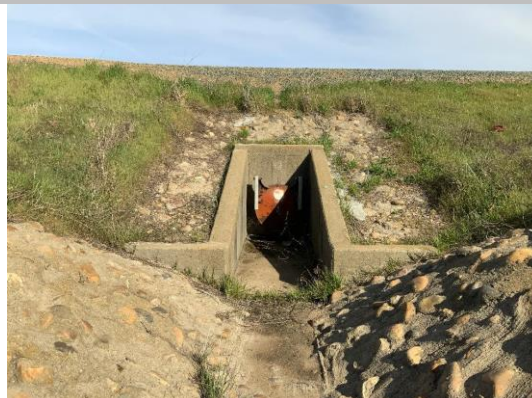
Photo 2 of 3 : UCIP_FA_2021_66882_92240.jpg

WS headwall and flapgate at toe.

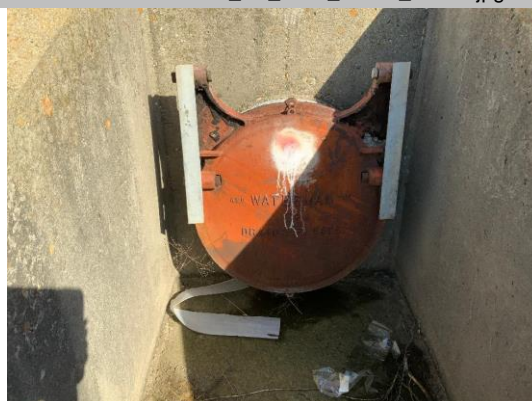
Photo 3 of 3 : UCIP_FA_2021_66882_92241.jpg

WS flapgate.

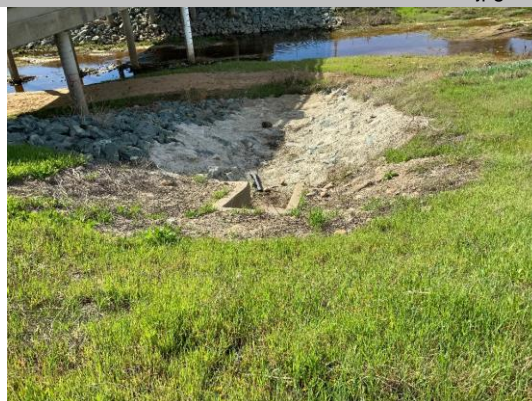
Photo 1 of 3 : UCIP_FA_2021_66808_92247.jpg

Comment Code						
Inspector Comment						
DS_ID:23594 FS_ID:66808 EP_NO: N/A Repair Type: Non-Urgent EVAL Issue: Unauthorized Encroachment, installed decades prior Crossing Status: Found UCIP Comments: 02/25/2021 The record has been upgraded from No Action Needed to Non-Urgent. In August 2018, under the DWR DMP efforts the internal inspection found integrity issues, LOF between 5 and 6. According to Mr. Eric Ambriz, with San Joaquin County, Caltrans completed the slip Snap-Tite lining effort in October 2018. There is currently no post install inspection of the Snap-Tite lining. No permit was found authorizing this encroachment. CVFPB will need to review crossing to determine owner. The UCIP inspection was completed with LMA representative, M. McCoy. (H. Dunn – GEI) 10/10/2018 20-inch Snap-Tite lining pipes were sleeved through the damaged 24-inch CMP culvert. Annular space was pressure grouted. (A. McDonald - DWR UCIP) FIELD_STRUCT_DESC: 24-inch corrugated metal drainage culvert through the levee, 7.5 feet below the crown. 20-inch Snap-Tite lining pipes sleeved through the 24-inch corrugated metal drainage culvert, 10/09/2018. Annular space pressure grouted, 10/10/2018. Flap gate on the waterside (WS) end. Concrete U-shaped headwall on each end. Cobble grouted spillway across berm. Cobble grouted apron on the landside (LS) end. [Additional Reference(s): DWR Levee Log, 1987. USACE San Joaquin O&M Manual 612.2, 1967, (HLM 12.40)]. FS Date: 2/25/2021

WS view: WS headwall at toe from crown.

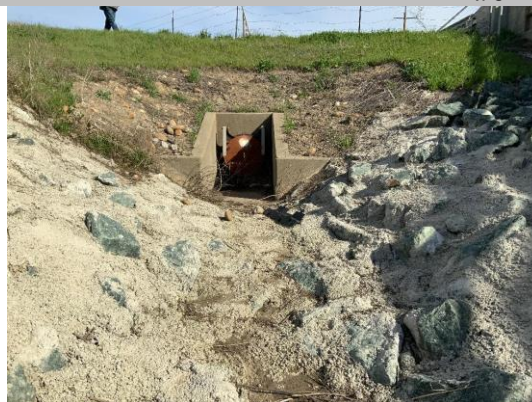
Photo 2 of 3 : UCIP_FA_2021_66808_92248.jpg

WS view: WS headwall and flapgate at toe.

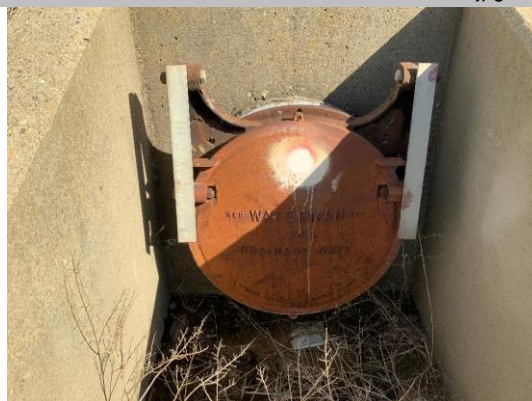
Photo 3 of 3 : UCIP_FA_2021_66808_92249.jpg

WS view: WS flapgate.

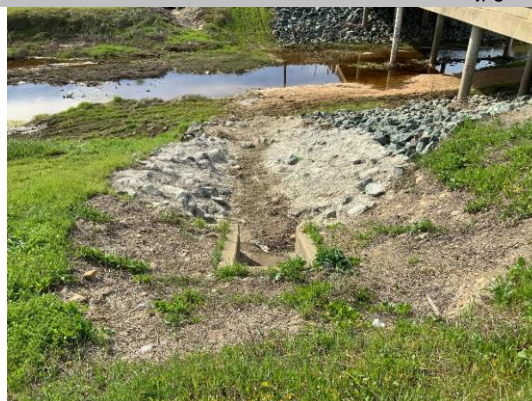
Photo 1 of 3 : UCIP_FA_2021_64144_92256.jpg

DS_ID:23505
 FS_ID:64144
 EP_NO: N/A
 Repair Type: Non-Urgent
 EVAL Issue: Unauthorized Encroachment, installed decades prior
 Crossing Status: Found
 UCIP Comments: 02/25/2021 The record has been upgraded from No Action Needed to Non-Urgent. Edges of LS pipe are warped. DWR DMP has not found internal issues, LOF between 1 and 2. Recommend inspection in 5 years. No permit was found authorizing this encroachment. CVFPB will need to review crossing to determine owner. The UCIP inspection was completed with LMA representative, M. McCoy. (H. Dunn – GEI)
 FIELD_STRUCT_DESC: 24-inch corrugated metal drainage pipe through the levee, 7.5 feet below the crown. Flap gate on the waterside (WS) end. Concrete U-shaped headwalls on both ends. Cobble grouted spillway across the berm. Cobble grouted apron on the landside (LS) end. [Additional Reference(s): DWR Levee Log, 1987. USACE San Joaquin O&M Manual 612.2, 1967, (HLM 12.42)].

WS view: WS headwall at toe from crown.

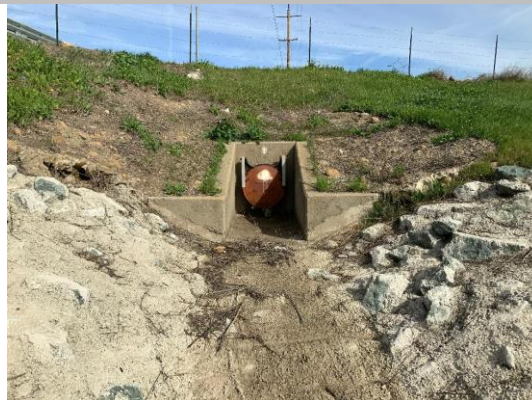
Photo 2 of 3 : UCIP_FA_2021_64144_92257.jpg

WS view: WS headwall and flapgate at toe.

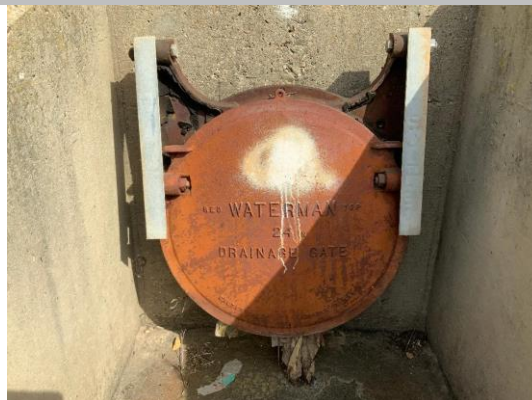
Photo 3 of 3 : UCIP_FA_2021_64144_92258.jpg

WS view: WS flapgate.
