**Flood Control Project Maintenance
Levee Inspections**

Maintenance Issue Types Only, Levee Inspection Report By Mile - Fall 2021

San Joaquin County Flood Control and Water Conservation District

Waterway	Bank	Unit Miles	Inspection Start/End	Inspector
Unit No. 01 Littlejohn Creek	Left	2.59	10/21/2021 10/21/2021	Alberto De Leon

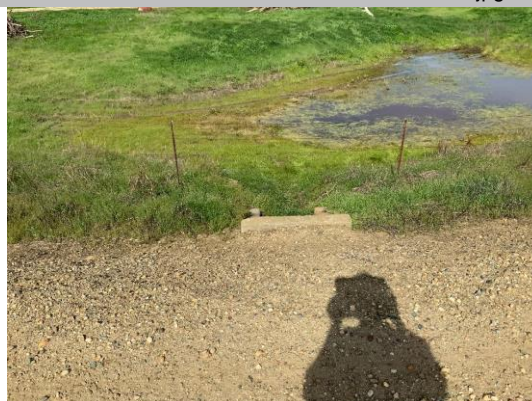
Photo 1 of 3 : UCIP_FA_2021_64146_92274.jpg

Comment Code						
Inspector Comment						
DS_ID:23507 FS_ID:64146 EP_NO: N/A Repair Type: Non-Urgent EVAL Issue: Unauthorized Encroachment, installed decades prior Crossing Status: Found UCIP Comments: 02/25/2021 The record has been upgraded from No Action Needed to Non-Urgent. DWR DMP has not found internal issues, LOF between 1 and 2. Recommend inspection in 5 years. No permit was found authorizing this encroachment. CVFPB will need to review crossing to determine owner. The UCIP inspection was completed with LMA representative, M. McCoy. (H. Dunn – GEI) FIELD_STRUCT_DESC: 24-inch corrugated metal storm drainage pipe through the levee, 7.5 feet below the crown. Flap gate on the waterside (WS) end. Concrete U-shaped headwalls on both ends. Cobble grouted spillway across the berm. Cobble grouted apron on the landside (LS) end. [Additional Reference(s): DWR Levee Log, 1987. USACE San Joaquin O&M Manual 612.2, 1967, (HLM 12.64) and 612 (addendum), February 1999, (HLM 12.61) (Station 666+02)]. FS Date: 2/25/2021

LS view: LS headwall at toe from crown.

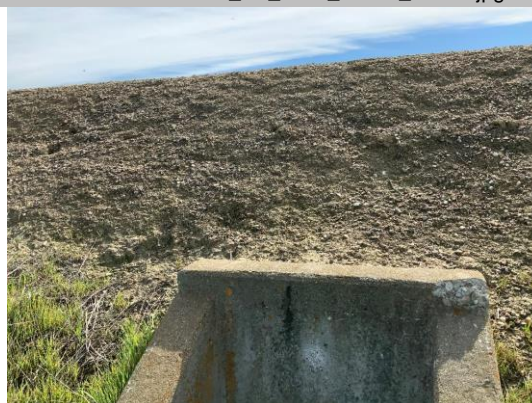
Photo 2 of 3 : UCIP_FA_2021_64146_92276.jpg

LS view: LS headwall at toe.

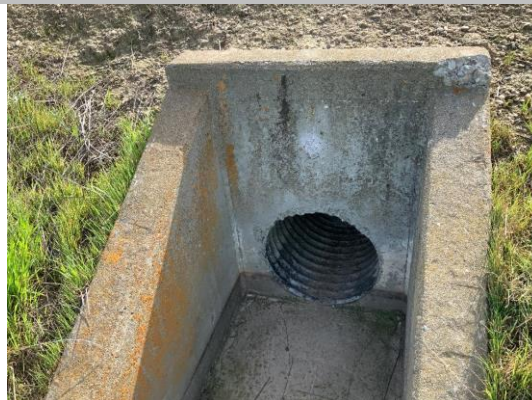
Photo 3 of 3 : UCIP_FA_2021_64146_92275.jpg

LS view: LS headwall at toe.

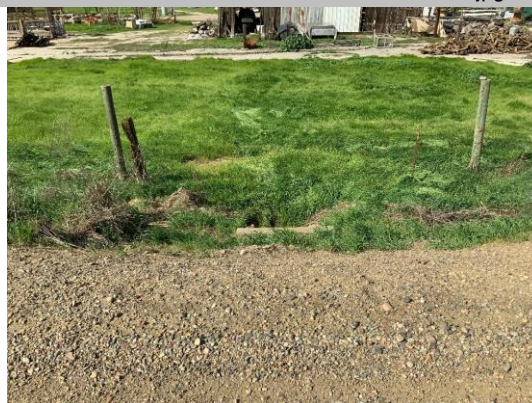
Photo 1 of 3 : UCIP_FA_2021_66809_92282.jpg

DS_ID:23508
 FS_ID:66809
 EP_NO: N/A
 Repair Type: Non-Urgent
 EVAL Issue: Pipe Damage
 Crossing Status: Found
 UCIP Comments: 02/25/2021 The record has been upgraded from No Action Needed to Non-Urgent. DWR DMP has found integrity issues, LOF between 4 and 5. Crossing will be monitored until funding becomes available for rehabilitation. Recommend maintenance to clear up sediment buildup through LS pipe. No permit was found authorizing this encroachment. CVFPB will need to review crossing to determine owner. The UCIP inspection was completed with LMA representative, M. McCoy. (H. Dunn – GEI)
 FIELD_STRUCT_DESC: 24-inch corrugated metal storm drainage pipe through the levee, 7.5 feet below the crown. Flap gate on the waterside (WS) end. Concrete U-shaped headwalls on both ends. Cobble grouted spillway across the berm. Cobble grouted apron on the landside (LS) end. [Additional Reference(s): DWR Levee Log, 1987. USACE San Joaquin O&M Manual 612.2, 1967, (HLM 12.72) and 612 (addendum), February 1999, (HLM 12.71) (Station 671+24)].

LS view: LS headwall at toe from crown.

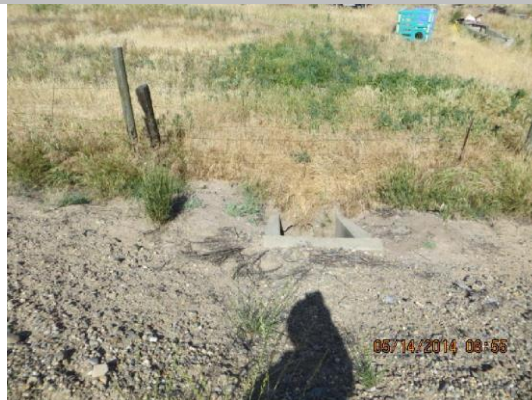
Photo 2 of 3 : UCIP_FA_2021_66809_68555.jpg

Pipe and headwall at LS toe.

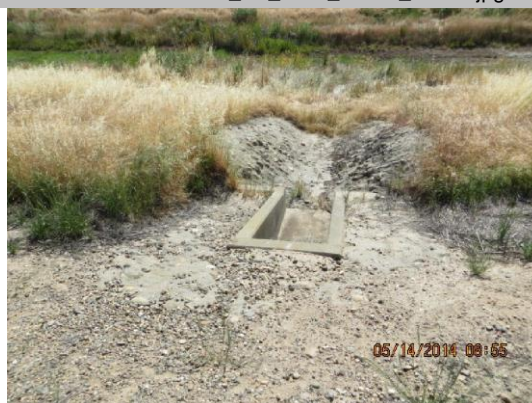
Photo 3 of 3 : UCIP_FA_2021_66809_68554.jpg

Pipe, flapgate, headwall, and grouted spillway on WS toe.

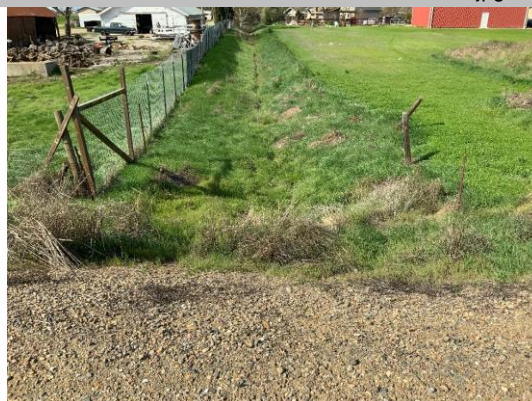
Photo 1 of 3 : UCIP_FA_2021_66810_92291.jpg

Comment Code					
Inspector Comment					
DS_ID:23509 FS_ID:66810 EP_NO: N/A Repair Type: Non-Urgent EVAL Issue: Unauthorized Encroachment, installed decades prior Crossing Status: Found UCIP Comments: 02/25/2021 The record has been upgraded from No Action Needed to Non-Urgent. DWR DMP internal inspection has not found pipe integrity issues. LOF of crossing is less or equal to 4.0. Recommend next video inspection in 5 years. No permit was found authorizing this encroachment. CVFPB will need to review crossing to determine owner. The UCIP inspection was completed with LMA representative, M. Mccoy. (H. Dunn – GEI) FIELD_STRUCT_DESC: 24-inch corrugated metal storm drainage pipe through the levee, 7.5 feet below the crown. Flap gate on the waterside (WS) end. Concrete U-shaped headwalls on both ends. Cobble grouted spillway across the berm. Cobble grouted apron on the landside (LS) end. [Additional Reference(s): DWR Levee Log, 1987. USACE San Joaquin O&M Manual 612.2, 1967, (HLM 12.74) and 612 (addendum), February 1999, (HLM 12.73) (Station 672+05)]. FS Date: 2/25/2021

LS view: LS headwall at toe from crown.

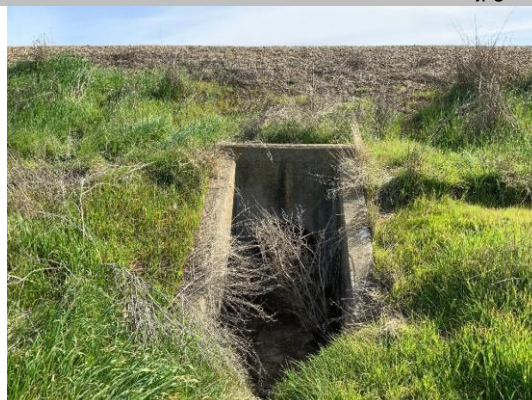
Photo 2 of 3 : UCIP_FA_2021_66810_95682.jpg

LS view: Headwall at toe.

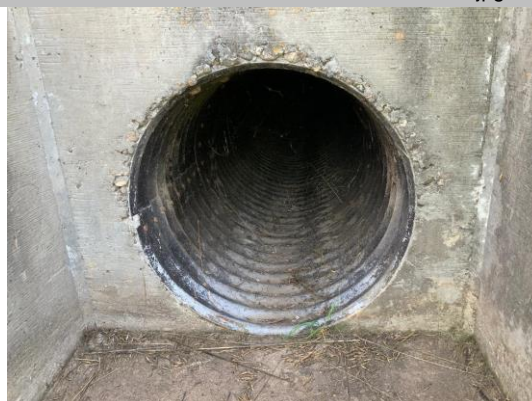
Photo 3 of 3 : UCIP_FA_2021_66810_95683.jpg

LS view: Pipe inlet, 1 of 2 photos.

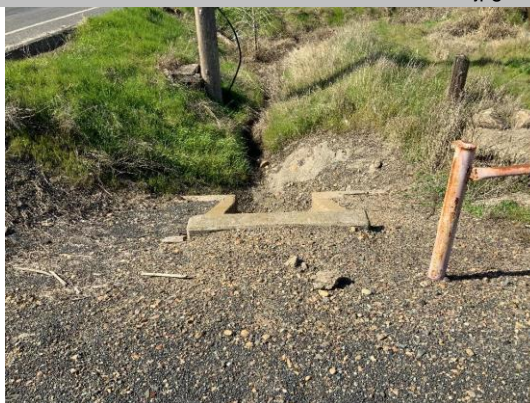
Photo 1 of 3 : UCIP_FA_2021_64186_92340.jpg

Comment Code						
Inspector Comment						
DS_ID:23512						
FS_ID:64186						
EP_NO: N/A						
Repair Type: Non-Urgent						
EVAL Issue: Unauthorized Encroachment, installed decades prior						
Crossing Status: Found						
UCIP Comments: 02/25/2021 The record has been upgraded from No						
Action Needed to Non-Urgent. DWR DMP has not found internal						
issues, LOF between 1 and 2. Recommend inspection in 5 years. No						
permit was found authorizing this encroachment. CVFPB will need to						
review crossing to determine owner. The UCIP inspection was						
completed with LMA representative, M. Mccoy. (H. Dunn – GEI)						
FIELD_STRUCT_DESC: 24-inch corrugated metal drainage pipe						
through the levee, 7 feet below the crown. Concrete U-shaped headwall						
on both ends. Flap gate on the waterside (WS) end. Cobble grouted						
spillway. Cobble grouted intake on the landside (LS). [Additional

LS view: LS headwall at toe from crown.

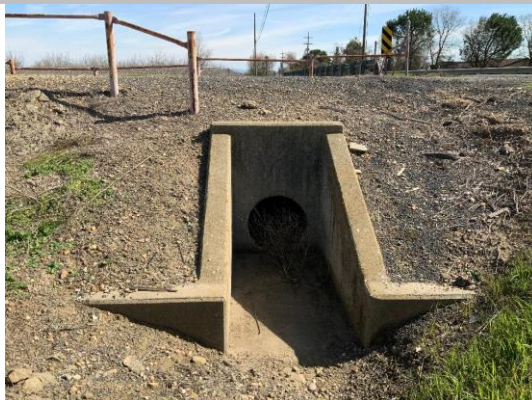
Photo 2 of 3 : UCIP_FA_2021_64186_92341.jpg

LS view: LS headwall at toe.

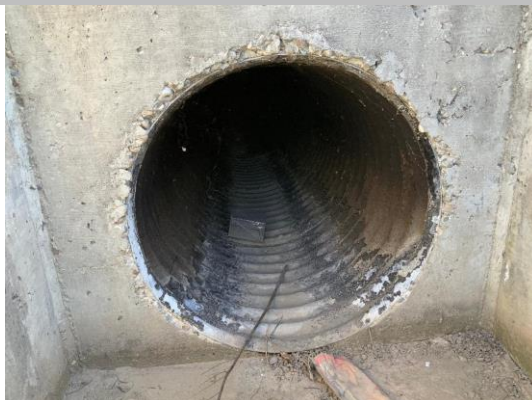
Photo 3 of 3 : UCIP_FA_2021_64186_92342.jpg

LS view: LS pipe.

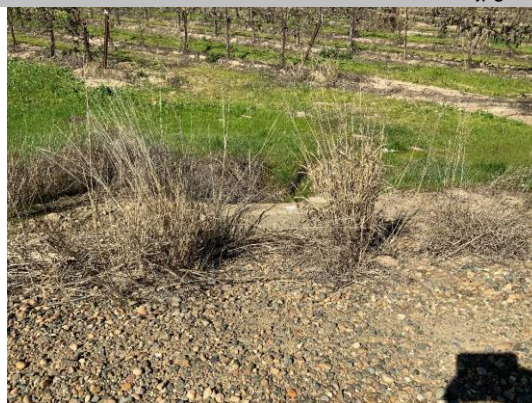
Photo 1 of 3 : UCIP_FA_2021_64192_92446.jpg

Comment Code						
Inspector Comment						
DS_ID:23597 FS_ID:64192 EP_NO: N/A Repair Type: Non-Urgent EVAL Issue: Unauthorized Encroachment, installed decades prior Crossing Status: Found UCIP Comments: 02/25/2021 The record has been upgraded from No Action Needed to Non-Urgent. DWR DMP has not found internal issues, LOF between 1 and 2. Recommend inspection in 5 years. No permit was found authorizing this encroachment. CVFPB will need to review crossing to determine owner. The UCIP inspection was completed with LMA representative, M. Mccoy. (H. Dunn – GEI) FIELD_STRUCT_DESC: 24-inch corrugated metal drainage pipe through the levee, 5.5 feet below the crown. Concrete U-shaped headwall on both ends. Flap gate on the waterside (WS) slope. Cobble grouted spillway. Cobble grouted intake on the landside (LS). [Additional Reference(s): DWR Levee Log, 1987. USACE San Joaquin O&M Manual 612.2, 1967, (HLM 13.64)]. FS Date: 2/25/2021

LS view: LS headwall at toe from crown.

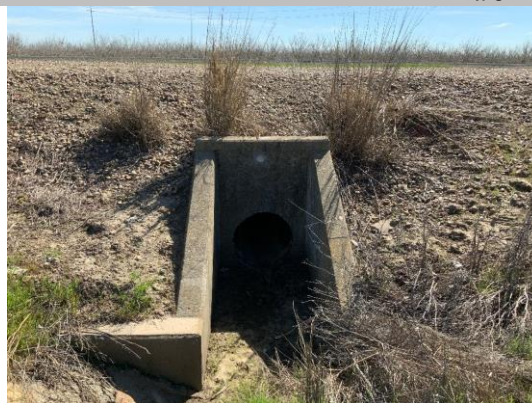
Photo 2 of 3 : UCIP_FA_2021_64192_92447.jpg

LS view: LS headwall at toe.

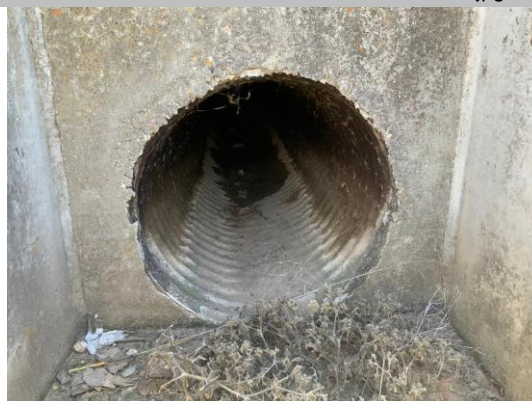
Photo 3 of 3 : UCIP_FA_2021_64192_92448.jpg

LS view: LS pipe.

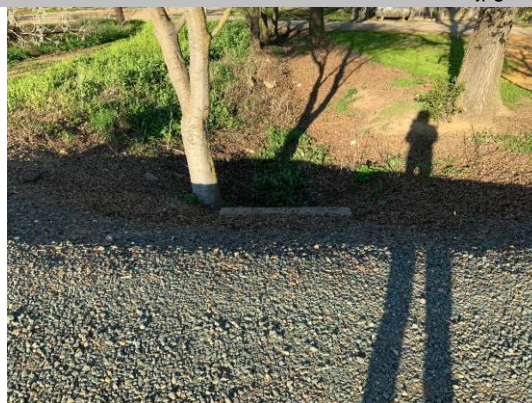
Photo 1 of 3 : UCIP_FA_2021_64193_92704.jpg

DS_ID:23598
FS_ID:64193
EP_NO: N/A
Repair Type: Non-Urgent
EVAL Issue: Unauthorized Encroachment, installed decades prior
Crossing Status: Found
UCIP Comments: 02/26/2021 The record has been upgraded from No Action Needed to Non-Urgent. DWR DMP has not found internal issues, LOF between 1 and 2. Recommend inspection in 5 years. No permit was found authorizing this encroachment. CVFPB will need to review crossing to determine owner. The UCIP inspection was completed with LMA representative, J. Caruso. (H. Dunn – GEI)
FIELD_STRUCT_DESC: 24-inch corrugated metal drainage pipe through the levee, 7.5 feet below the crown. Concrete U-shaped headwall on both ends. Flap gate on the waterside (WS) end. Cobble grouted spillway. Cobble grouted intake on the landside (LS) slope.
[Additional Reference(s): DWR Levee Log, 1987. USACE San Joaquin O&M Manual 612.2, 1967, (HLM 14.04)].
FS Date: 2/26/2021

LS headwall at toe from crown.

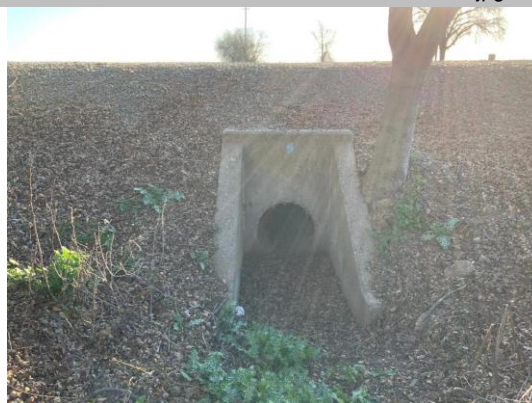
Photo 2 of 3 : UCIP_FA_2021_64193_92705.jpg

LS headwall at toe.

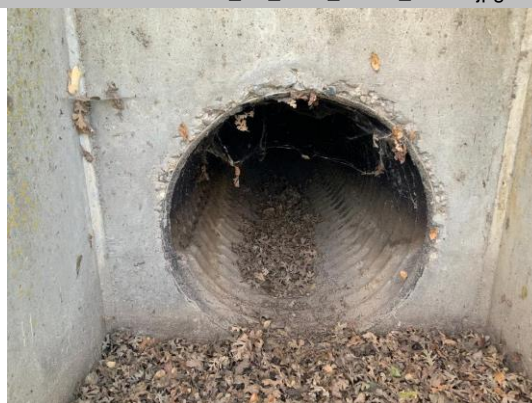
Photo 3 of 3 : UCIP_FA_2021_64193_92706.jpg

LS pipe.

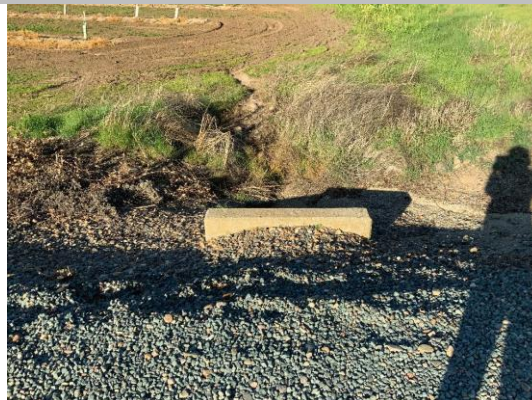
Photo 1 of 3 : UCIP_FA_2021_64196_92726.jpg

Comment Code					
Inspector Comment					
DS_ID:23600 FS_ID:64196 EP_NO: N/A Repair Type: Non-Urgent EVAL Issue: Unauthorized Encroachment, installed decades prior Crossing Status: Found UCIP Comments: 02/26/2021 The record has been upgraded from No Action Needed to Non-Urgent. DWR DMP has not found internal issues, LOF between 1 and 2. Recommend inspection in 5 years. No permit was found authorizing this encroachment. CVFPB will need to review crossing to determine owner. The UCIP inspection was completed with LMA representative, J. Caruso. (H. Dunn – GEI) FIELD_STRUCT_DESC: 24-inch corrugated metal drainage pipe through the levee, 6 feet below the crown. Concrete U-shaped headwall on both ends. Flap gate on the waterside (WS) end. Cobble grouted spillway. [Additional Reference(s): DWR Levee Log, 1987. USACE San Joaquin O&M Manual 612.2, 1967, (HLM 14.37)]. FS Date: 2/26/2021

LS view: LS headwall at toe from crown.

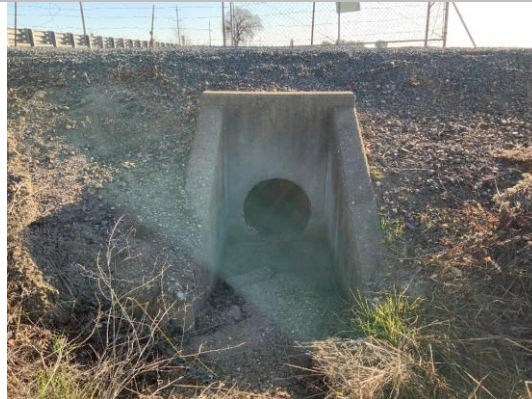
Photo 2 of 3 : UCIP_FA_2021_64196_92727.jpg

LS view: LS headwall at toe.

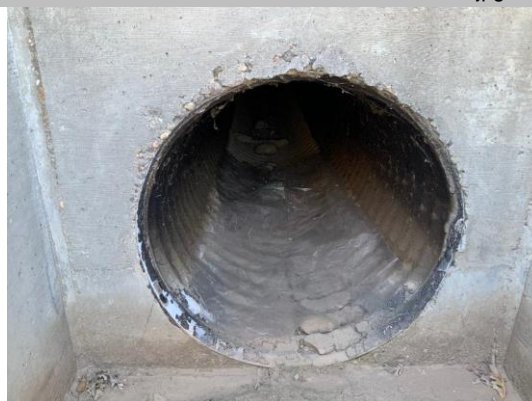
Photo 3 of 3 : UCIP_FA_2021_64196_92728.jpg

LS view: LS pipe.

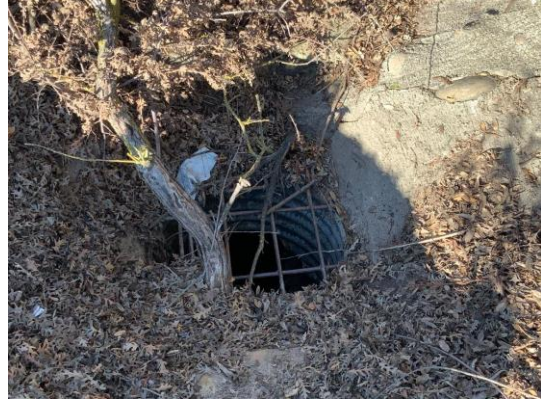
Photo 2 of 3 : UCIP_FA_2021_66821_92738.jpg

Comment Code					
Inspector Comment					
DS_ID:23601 FS_ID:66821 EP_NO: N/A Repair Type: Non-Urgent EVAL Issue: Pipe Damage Crossing Status: Found UCIP Comments: 02/26/2021 Record record has been updated from No Action Needed to Non-Urgent. DWR DMP has found integrity issues, LOF between 4 and 5. Crossing will be monitored until funding becomes available for rehabilitation. No permit was found authorizing this encroachment. CVFPB will need to review crossing to determine owner. The UCIP inspection was completed with LMA representative, J. Caruso. (H. Dunn GEI) FIELD_STRUCT_DESC: 24-inch corrugated metal drainage pipe through the levee, 8 feet below the crown. Concrete U-shaped headwall on the waterside (WS) end. Flap gate on the WS end. Cobble grouted spillway. 24-inch corrugated metal drop inlet and cobble grouted intake on the landside (LS), no headwall. (Drainage ditch and 12-inch culverts adjacent to levee installed under Permit No. 12659, 1979 - Richard Stasand). [Additional Reference(s): DWR Levee Log, 1987. USACE San Joaquin O&M Manual 612.2, 1967, (HLM 14.39)]. FS Date: 2/26/2021

LS view: LS toe pipe and inlet.

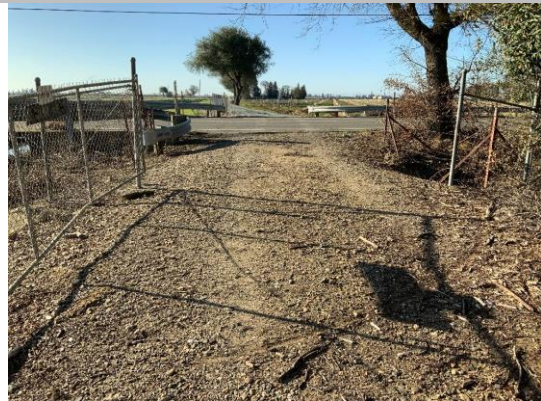
Photo 3 of 3 : UCIP_FA_2021_66821_92733.jpg

Levee crown looking downstream.

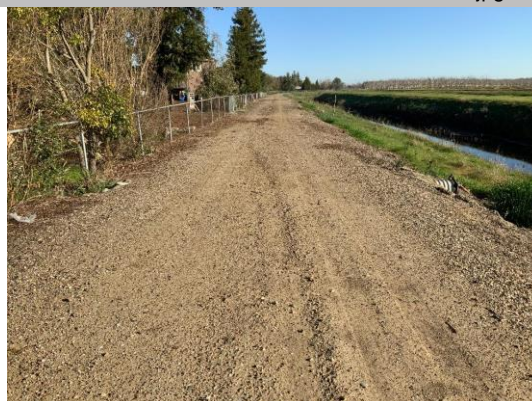
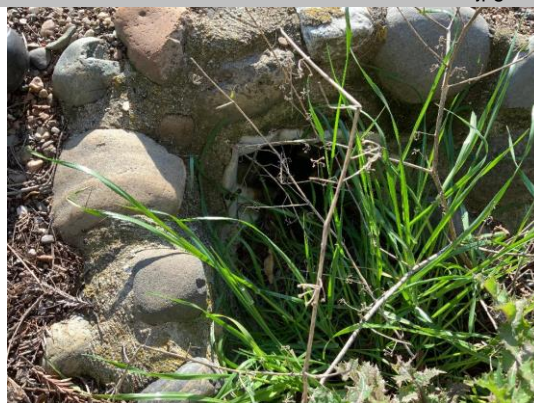
LM Start	13.87	Rating **	U	Issue No.	1208 (cont)
LM End	13.87	Issue Type +	Ma	Location *

Comment Code					
Inspector Comment					
DS_ID:23602 FS_ID:66822 EP_NO: N/A Repair Type: Urgent EVAL Issue: Pipe Integrity Crossing Status: Found UCIP Comments: 02/26/2021 Record has been updated from No Action Needed to Urgent. DWR DMP has found integrity issues, LOF between 5 and 6. Recommend monitoring crossing until funding becomes available to address. LS spillway is slightly overgrown with vegetation. No permit was found authorizing this encroachment. CVFPB will need to review crossing to determine owner. LS flap gate is broken and needs repair. The UCIP inspection was completed with LMA representative, J. Caruso. (H. Dunn – GEI) FIELD_STRUCT_DESC: 12-inch corrugated metal drainage pipe through the levee, 1 foot below the crown. Cobble grouted inlet at fish pond on the landside (LS) toe. [Additional Reference(s): DWR Levee Log, 1987. USACE San Joaquin O&M Manual 612.2, 1967, (HLM 14.42) 7-inch pipe listed]. FS Date: 2/26/2021

Levee crown looking upstream.

LS view: LS inlet at toe from crown.

LS view: LS pipe at toe.

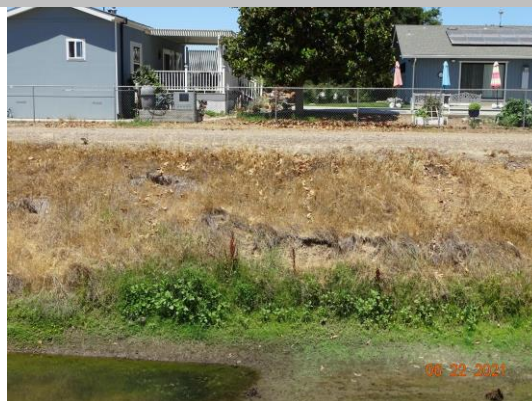
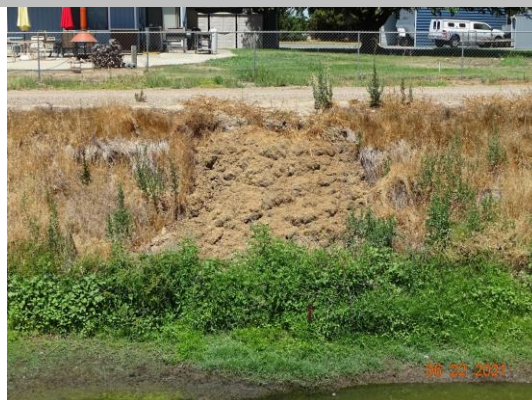
LM Start	14.02	Rating **	A/W	Issue No.	259 (cont)
LM End	14.04	Issue Type +	Ma	Location *

*This area is patrol road only and therefore the site is not rated
06/22/2021: An additional, 8-ft long erosion pocket was discovered just upstream that extends to the upper slope and is filled with loose plant material. Otherwise, no significant changes were observed during the annual survey.

6/22/2021: View of the erosion from the opposite bank.

6/22/2021: View of the upstream erosion pocket covered with loose material.

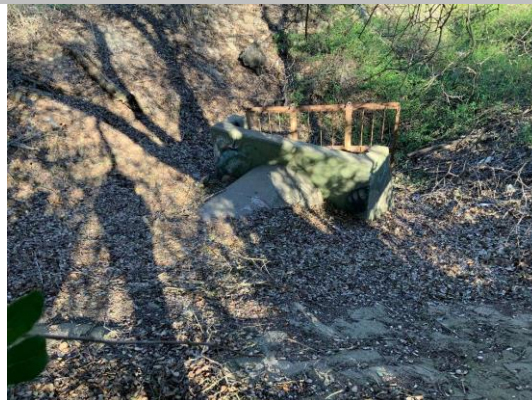
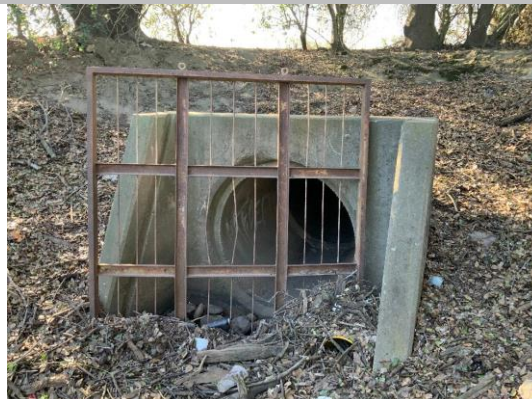
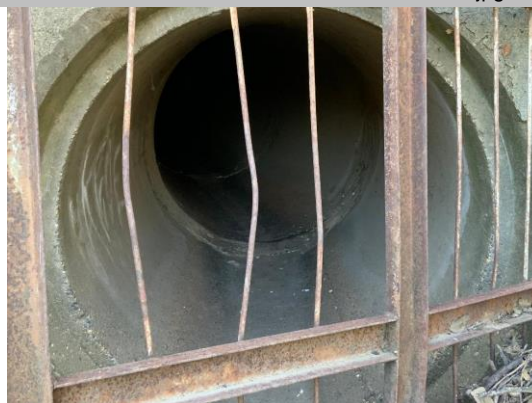
LM Start	14.45	Rating **	M	Issue No.	1209 (cont)
LM End	14.45	Issue Type +	Ma	Location *

Comment Code						
Inspector Comment						
DS_ID:23604 FS_ID:66826 EP_NO: N/A Repair Type: Non-Urgent EVAL Issue: Maintenance Compliance Issue Crossing Status: Found UCIP Comments: 02/26/2021 Record remains Non-Urgent. Unit 7 – Bear Creek (CLM 13.95 to 14.90) is considered a patrol road/high ground area with no defined levee prism, any issue found between CLM 13.95 to 14.90 of Unit 7 will be considered a maintenance issue, or an unauthorized encroachment, or an abandoned encroachment. DWR DMP has found integrity issues, LOF between 4 and 5. Current condition of pipe crossing does not impede access to patrol road/high ground area. No permit was found authorizing this encroachment. CVFPB will need to review crossing to determine owner.. The UCIP inspection was completed with LMA representative, J. Caruso. (H. Dunn – GEI) 05/12/2014 No flapgate. (W. Wylie - DWR UCIP) FIELD_STRUCT_DESC: 48-inch reinforced concrete drainage pipe, 9 feet below the crown. Concrete headwall with trash rack on the landside (LS). Cobble grouted intake on the LS. Cobble grouted spillway. Open on both ends. [Additional Reference(s): DWR Levee Log, 1987. USACE San Joaquin O&M Manual 612.2, 1967, (HLM 15.00)]. FS Date: 2/26/2021

LS view: LS headwall off of the toe.

LS view: LS headwall, gate adjar, no flapgate.

LS view: LS pipe.

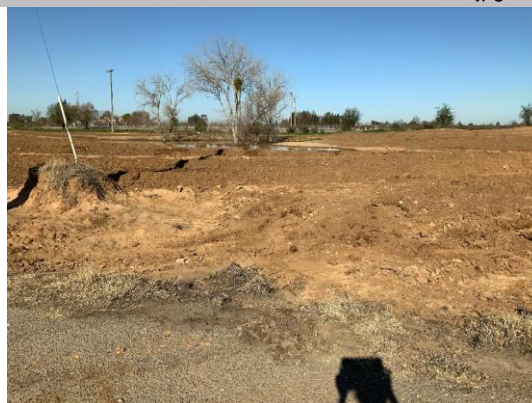
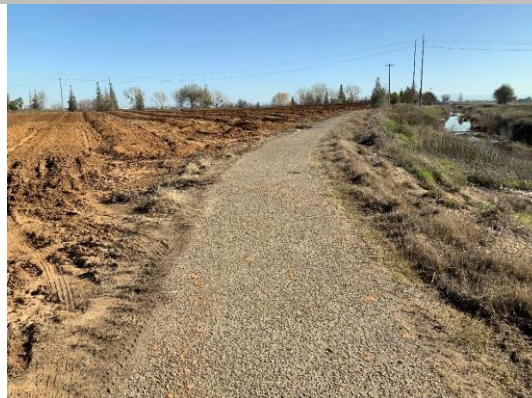
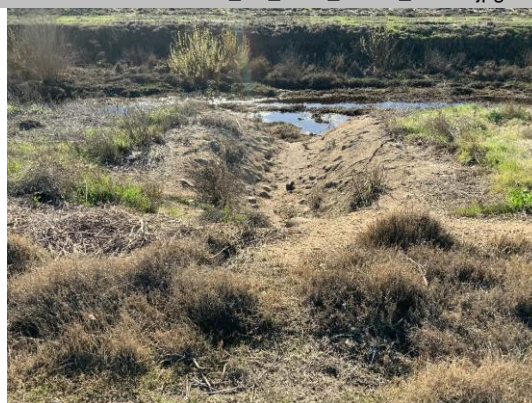
LM Start	14.54	Rating **	M	Issue No.	1211
LM End	14.54	Issue Type +	Ma	Location *	
Category	Supplemental			GPS Latitude/Longitude	
				Start	End
Item	DWR UCIP LMA Responsibility			38.125671 °	38.125671 °
				-121.167975 °	-121.167975 °
DWR ID	23605

LS toe from crown, pipe not visible.

Comment Code					
Inspector Comment					
<p>DS_ID:23605 FS_ID:66828 EP_NO: N/A Repair Type: Non-Urgent EVAL Issue: Unauthorized Encroachment, installed decades prior Crossing Status: Found UCIP Comments: 02/26/2021 Record remains Non-Urgent. Unit 7 – Bear Creek (CLM 13.95 to 14.90) is considered a patrol road/high ground area with no defined levee prism, any issue found between CLM 13.95 to 14.90 of Unit 7 will be considered a maintenance issue, or an unauthorized encroachment, or an abandoned encroachment. DWR DMP has found integrity issues, LOF between 5 and 6. Crossing will be monitored until funding becomes available to address. Current condition of pipe crossing does not impede access to patrol road/high ground area. No permit was found authorizing this encroachment. CVFPB will need to review crossing to determine owner. The UCIP inspection was completed with LMA representative, J. Caruso. (H. Dunn – GEI)</p> <p>05/12/2014 No flapgate. Pipe not visible on LS. (W. Wylie - DWR UCIP) FIELD_STRUCT_DESC: 14-inch reinforced concrete drainage pipe through the levee, 4.7 feet below the crown. Cobble grouted spillway. Open on both ends. [Additional Reference(s): DWR Levee Log, 1987, 12-inch pipe listed. USACE San Joaquin O&M Manual 612.2, 1967, (HLM 15.10) 12-inch pipe listed]. FS Date: 2/26/2021</p>

Levee crown looking upstream.

WS view: WS pipe at toe from crown.

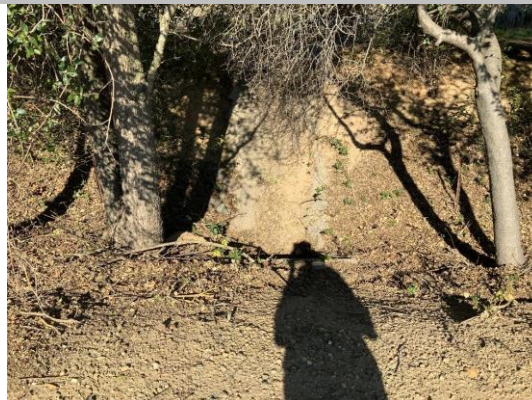
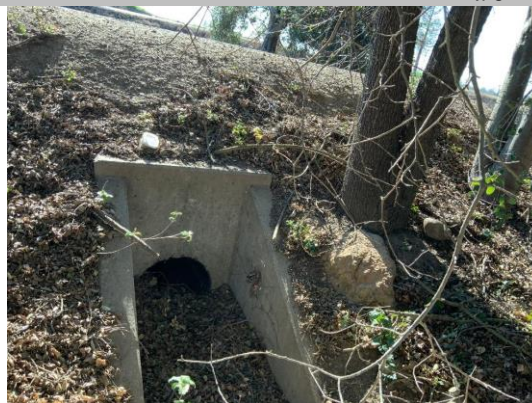
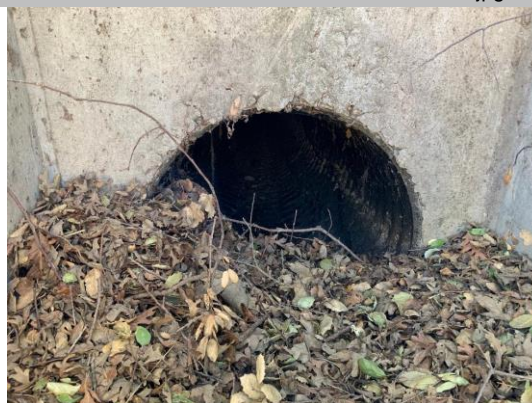
LM Start	14.93	Rating **	M	Issue No.	1213 (cont)
LM End	14.93	Issue Type +	Ma	Location *

Comment Code						
Inspector Comment						
DS_ID:23607 FS_ID:64208 EP_NO: N/A Repair Type: Non-Urgent EVAL Issue: Unauthorized Encroachment, installed decades prior Crossing Status: Found UCIP Comments: 02/26/2021 The record has been upgraded from No Action Needed to Non-Urgent. DWR DMP has not found internal issues, LOF between 1 and 2. Recommend inspection in 5 years. No permit was found authorizing this encroachment. CVFPB will need to review crossing to determine owner. The UCIP inspection was completed with LMA representative, J. Caruso. (H. Dunn – GEI) FIELD_STRUCT_DESC: 24-inch corrugated metal drainage pipe through the levee, 5.5 feet below the crown. Concrete U-shaped headwalls on both ends. Flap gate on the waterside (WS) end. Cobble grouted spillway. Cobble grouted intake on the landside (LS). [Additional Reference(s): DWR Levee Log, 1987. USACE San Joaquin O&M Manual 612.2, 1967, (HLM 15.50)]. FS Date: 2/26/2021

LS view: LS headwall at toe from crown.

LS view: LS headwall at toe.

LS view: LS pipe, vegetation debris covering pipe.

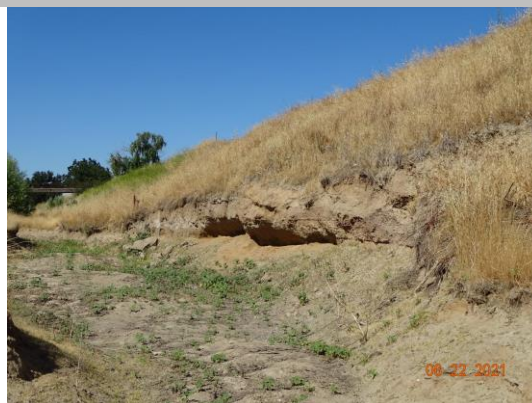
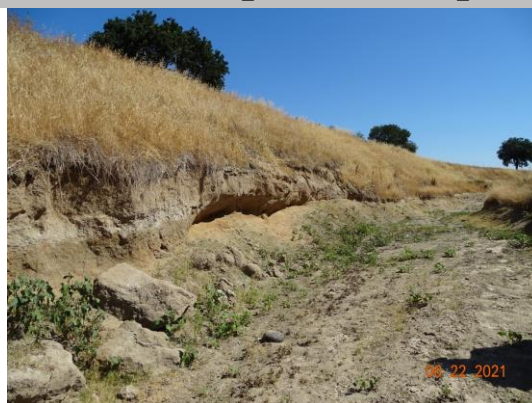
LM Start	15.07	Rating **	A/W	Issue No.	2 (cont)
LM End	15.08	Issue Type +	Ma	Location *

6/22/2021: View of the erosion looking downstream.

6/22/2021: View of the erosion looking upstream.

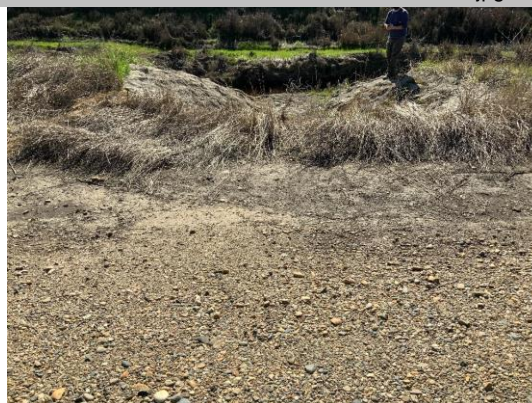
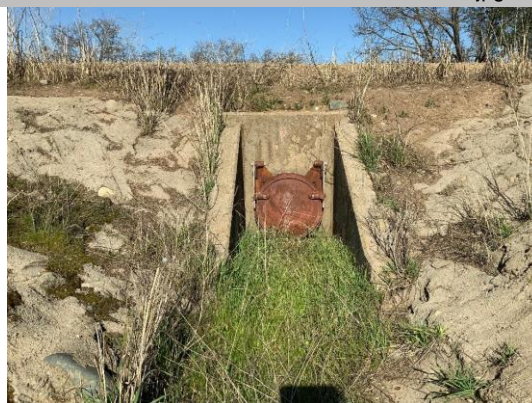
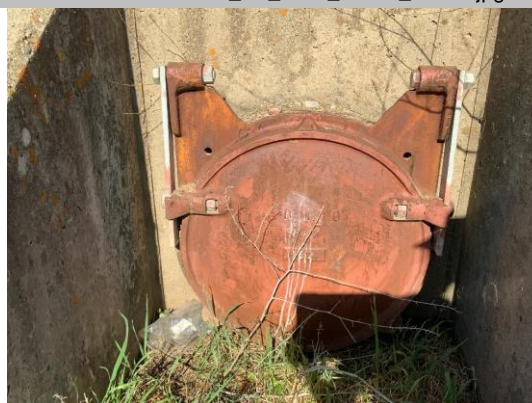
LM Start	15.10	Rating **	M	Issue No.	1219 (cont)
LM End	15.10	Issue Type +	Ma	Location *	
Category	Supplemental			GPS Latitude/Longitude	
				Start	End
Item	DWR UCIP LMA Responsibility			38.129803 °	38.129803 °
				-121.159474 °	-121.159474 °
DWR ID	23609

Comment Code					
Inspector Comment					
DS_ID:23609 FS_ID:66835 EP_NO: N/A Repair Type: Non-Urgent EVAL Issue: Unauthorized Encroachment, installed decades prior Crossing Status: Found UCIP Comments: 02/26/2021 The record has been upgraded from No Action Needed to Non-Urgent. DWR DMP has not found internal issues, LOF between 1 and 2. Recommend inspection in 5 years. No permit was found authorizing this encroachment. CVFPB will need to review crossing to determine owner. The UCIP inspection was completed with LMA representative, J. Caruso. (H. Dunn – GEI) 05/12/2014 Rodent hole on crown side of headwall on WS slope. (W. Wylie - DWR UCIP) FIELD_STRUCT_DESC: 24-inch corrugated metal drainage pipe through the levee, 7.5 feet below the crown. Concrete U-shaped headwall on both ends. Flap gate on the waterside (WS) end. Cobble grouted spillway. Cobble grouted intake on the landside (LS). [Additional Reference(s): DWR Levee Log, 1987. USACE San Joaquin O&M Manual 612.2, 1967, (HLM 15.68)]. FS Date: 2/26/2021

WS view: WS headwall at toe from crown.

WS view: WS headwall and flapgate at toe.

WS view: WS flapgate.

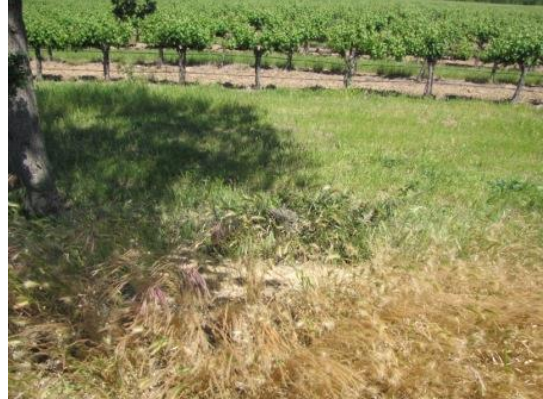
LM Start	15.16	Rating **	N	Issue No.	53
LM End	15.16	Issue Type +	Ma	Location *	LS
Category	Earthen Levee			GPS Latitude/Longitude	
				Start	End
Item	Trim / Thin Trees			38.130231 °	38.130231 °
				-121.158447 °	-121.158447 °
DWR ID	DWR_NA0017_07_s_2012_53				
Comment Code					
T5 : Tree stumps.					
Inspector Comment

View of a stump in the landward slope.

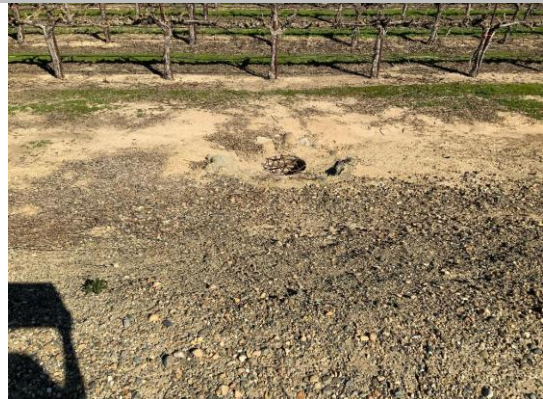
LM Start	15.22	Rating **	M	Issue No.	1220
LM End	15.22	Issue Type +	Ma	Location *	
Category	Supplemental			GPS Latitude/Longitude	
				Start	End
Item	DWR UCIP LMA Responsibility			38.130318 °	38.130318 °
				-121.157417 °	-121.157417 °
DWR ID	23610

Comment Code					
Inspector Comment					
DS_ID:23610 FS_ID:66885 EP_NO: N/A Repair Type: Non-Urgent EVAL Issue: Safety Issue Crossing Status: Found UCIP Comments: 02/26/2021 Pipe status is still Non-Urgent. LS inlet only has wiring covering it, no cover or riser, safety concern. DWR DMP has not found internal issues, LOF between 1 and 2. Recommend inspection in 5 years. No permit was found authorizing this encroachment. CVFPB will need to review crossing to determine owner. The UCIP inspection was completed with LMA representative, J. Caruso. (H. Dunn – GEI) 05/12/2014 No inlet cover or grate at LS toe. (W. Wylie - DWR UCIP) FIELD_STRUCT_DESC: 24-inch corrugated metal drainage pipe through the levee, 11 feet below the crown. Concrete U-shaped headwall on the waterside (WS) end. Flap gate on the WS end. 24-inch corrugated metal riser unit/drop inlet on the landside (LS). [Additional Reference(s): DWR Levee Log, 1987. USACE San Joaquin O&M Manual 612.2, 1967, (HLM 15.80)]. FS Date: 2/26/2021

LS view: LS toe from crown, pipe inlet with no riser.

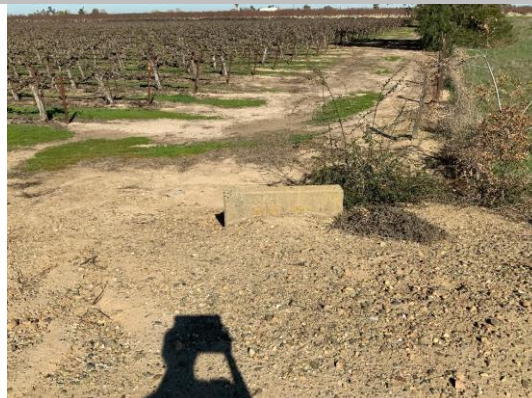
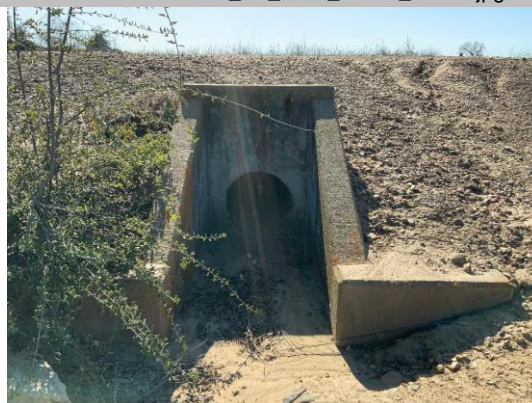
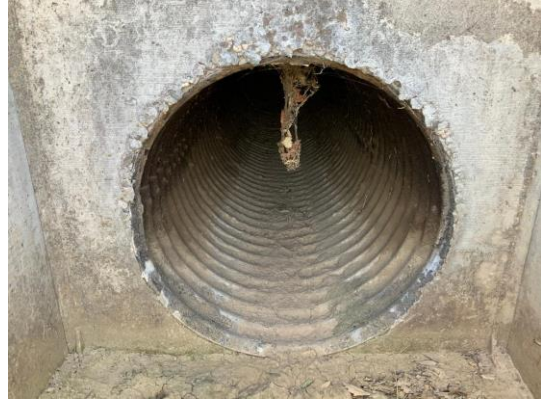
LM Start	15.31	Rating **	M	Issue No.	1221 (cont)
LM End	15.31	Issue Type +	Ma	Location *

Comment Code						
Inspector Comment						
DS_ID:23611 FS_ID:64216 EP_NO: N/A Repair Type: Non-Urgent EVAL Issue: Unauthorized Encroachment, installed decades prior Crossing Status: Found UCIP Comments: 02/26/2021 The record has been upgraded from No Action Needed to Non-Urgent. Some peeling away of metal on inside edge of WS pipe. DWR DMP has not found internal issues, LOF between 1 and 2. Recommend inspection in 5 years. No permit was found authorizing this encroachment. CVFPB will need to review crossing to determine owner. The UCIP inspection was completed with LMA representative, J. Caruso. (H. Dunn – GEI) FIELD_STRUCT_DESC: 24-inch corrugated metal drainage pipe through the levee, 4 feet below the crown. Concrete U-shaped headwall on both ends. Flap gate on the waterside (WS) end. Cobble grouted spillway. Cobble grouted intake on the landside (LS). [Additional Reference(s): DWR Levee Log, 1987. USACE San Joaquin O&M Manual 612.2, 1967, (HLM 15.90)]. FS Date: 2/26/2021

LS view: LS headwall at toe from crown.

LS view: LS headwall at toe.

LS view: LS pipe.

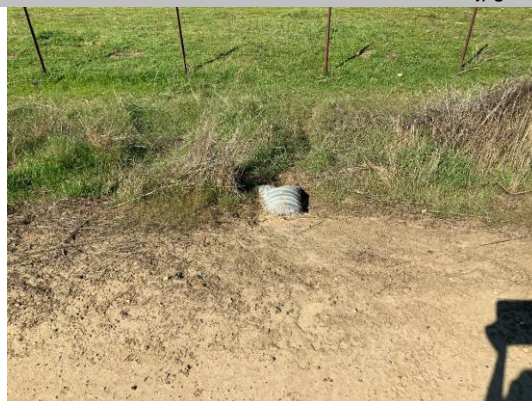
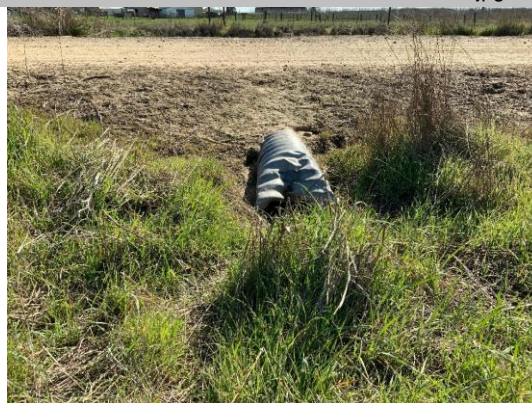
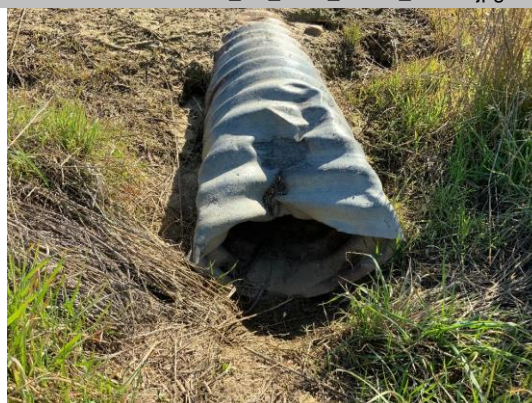
LM Start	15.51	Rating **	M	Issue No.	1222 (cont)
LM End	15.51	Issue Type +	Ma	Location *	
Category	Supplemental			GPS Latitude/Longitude	
				Start	End
Item	DWR UCIP LMA Responsibility			38.132632 °	38.132632 °
				-121.153838 °	-121.153838 °
DWR ID	23612

Comment Code						
Inspector Comment						
DS_ID:23612 FS_ID:66836 EP_NO: N/A Repair Type: Non-Urgent EVAL Issue: Maintenance Compliance Issue Crossing Status: Found UCIP Comments: 02/26/2021 Record remains Non-Urgent. Unit 7 – Bear Creek (CLM 15.50 to 16.13) is considered a patrol road/high ground area with no defined levee prism, any issue found between CLM 15.50 to 16.13 of Unit 7 will be considered a maintenance issue, or an unauthorized encroachment, or an abandoned encroachment. Current condition of pipe crossing does not impede access to patrol road/high ground area. Pipe is open on both ends and LS pipe edges are severely bent, recommend maintenance. No permit was found authorizing this encroachment. CVFPB will need to review crossing to determine owner. The UCIP inspection was completed with LMA representative, J. Caruso. (H. Dunn - GEI) 09/18/2018 Levee is so short that it's almost nonexistent. Pipe goes just under levee and acts as an open storm drain. Inlet is bent down. There is a flooding potential because this pipe is open and goes straight through the levee; therefore, this crossing remains "Urgent." (A. McDonald - DWR UCIP)04/20/2017 Pipe is open on both ends. Requires a positive closure device. Crossing has been upgraded from No Action Needed to Urgent. (K. Fazel - UCIP) FIELD_STRUCT_DESC: 12-inch corrugated metal drainage culvert through the levee, 1.5 feet below the crown. Cobble grouted spillway. Open on both ends. [Additional Reference(s): DWR Levee Log, 1987. USACE San Joaquin O&M Manual 612.2, 1967, (HLM 16.10)]. FS Date: 2/26/2021

LS view: LS pipe at toe from crown.

LS view: LS pipe at toe.

LS view: LS pipe, severely bent.

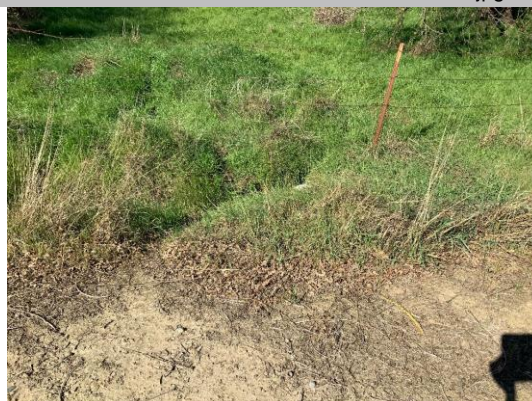
Comment Code						
Inspector Comment						
DS_ID:23614 FS_ID:66846 EP_NO: N/A Repair Type: Non-Urgent EVAL Issue: Maintenance Compliance Issue Crossing Status: Found UCIP Comments: 02/26/2021 Record remains Non-Urgent. Unit 7 – Bear Creek (CLM 15.50 to 16.13) is considered a patrol road/high ground area with no defined levee prism, any issue found between CLM 15.50 to 16.13 of Unit 7 will be considered a maintenance issue, or an unauthorized encroachment, or an abandoned encroachment. Pipe is barely a foot below crown and open on both WS and LS toes. WS has bad erosion and large burrow holes under and around it, recommend maintenance for open pipe and erosion. Pipe is surrounded by large pieces of broken concrete. No permit was found authorizing this encroachment. CVFPB will need to review crossing to determine owner. The UCIP inspection was completed with LMA representative, J. Caruso. (H. Dunn – GEI) 009/18/2018 Levee is so short that it's almost nonexistent. Pipe goes just under levee and acts as an open storm drain. There is a flooding potential because this pipe is open and goes straight through the levee; therefore, this crossing remains "Urgent." (A. McDonald - DWR UCIP)04/20/2017 Pipe is open on both ends. Requires a positive closure device. Crossing has been upgraded from No Action Needed to Urgent. (K. Fazel - UCIP) FIELD_STRUCT_DESC: 12-inch corrugated metal drainage culvert through the levee, 2 feet below the crown. Cobble grouted spillway. Open on both ends. [Additional Reference(s): DWR Levee Log, 1987. USACE San Joaquin O&M Manual 612.2, 1967, (HLM 16.32)]. FS Date: 2/26/2021

LS view: LS pipe at toe from crown.

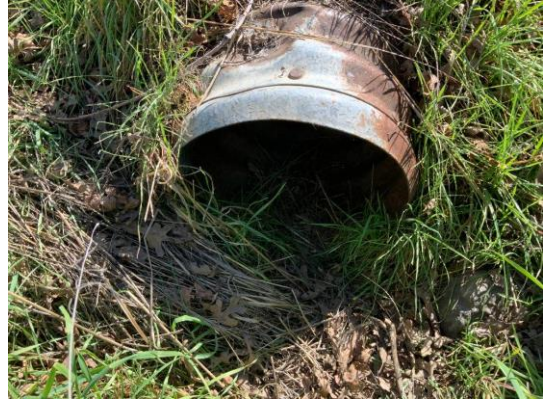
Photo 2 of 3 : UCIP_FA_2021_66846_92940.jpg

LS view: LS pipe, some bending on top.

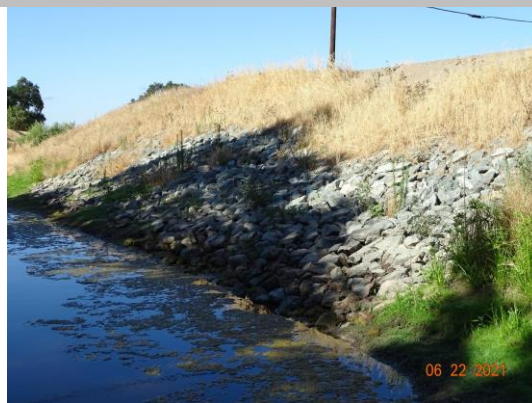
Photo 1 of 1 : SJR2021_NA0017U07RM23.14_1.JPG

LM Start	15.87	Rating **	A/W	Issue No.	3	
LM End	15.89	Issue Type +	Ma	Location *		
Category	Supplemental			GPS Latitude/Longitude		
				Start		End
Item	DWR Erosion Survey			38.137840 °		38.137840 °
				-121.152028 °		-121.152028 °
DWR ID	NA0017U07RM23.14					
Comment Code						
Inspector Comment						
Site ID: NA0017U07RM23.14 *This area is patrol road only and therefore the site is not rated 06/22/2021: The repair is holding up well; no new erosion is visible. 07/31/2020: The erosion has been repaired since the previous inspection and will be monitored for two years. The repair is 85 ft long and approximately 25 ft high. 08/01/2019: The erosion has cut into the patrol road and may impact access if not repaired. The erosion has likely been caused by surface runoff.

6/22/2021: View of the repaired erosion site looking downstream.

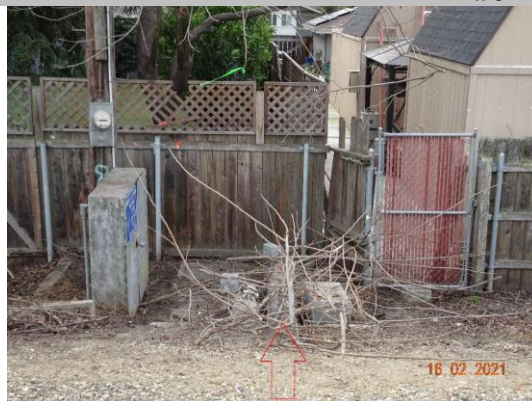
Photo 2 of 3 : UCIP_FA_2021_63706_93421.jpg

Comment Code						
Inspector Comment						
DS_ID:23731 FS_ID:63706 EP_NO: N/A Repair Type: Non-Urgent EVAL Issue: Unauthorized Encroachment, installed decades prior Crossing Status: Found UCIP Comments: 02/16/2021 Record was updated from No Action Needed to Non-Urgent. No permit was found authorizing this encroachment. CVFPB will need to review crossing to determine owner. Briar bush overgrowth limiting visual of WS toe. Working meter and control panel belonging Rancho San Joaquin Maintenance District Storm Water Facility at LS toe. LMA representative indicated utility belongs to the City of Stockton. The UCIP inspection was completed with DWR Inspector, O. Magana, and LMA representative, J. Caruso. (N. Cholewinski - GEI) FIELD_STRUCT_DESC: [Rancho San Joaquin Maintenance District Storm Water Facility] 1 of 2: 10-inch soil proofed steel drainage pipe through the levee, 3 feet below the crown. Flap gates on the waterside (WS) end. Siphon breaker in 24-inch corrugated metal riser unit on the WS slope. Pumps mounted over 6-foot by 7-foot concrete sump at the landside (LS) toe. Pole and electrical panel at same location. [Additional Reference(s): DWR Levee Log, 1990. USACE San Joaquin O&M Manual 612.1, June 1965, (HLM 2.18)]. FS Date: 2/16/2021

LS View: Pipe visible at LS toe. Electrical control panel and post adjacent to utility.

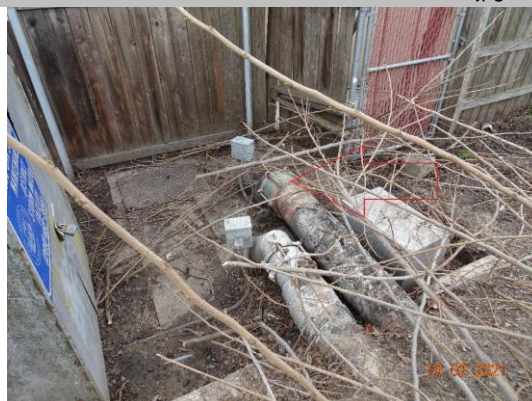
Photo 3 of 3 : UCIP_FA_2021_63706_93422.jpg

LS View: Pipe visible at LS toe. Electrical control panel and post adjacent to utility.

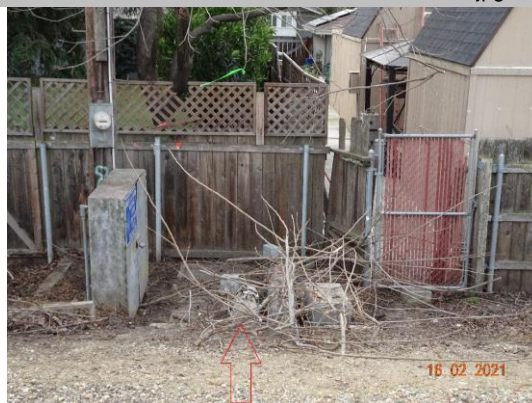
Photo 2 of 3 : UCIP_FA_2021_63707_93413.jpg

DS_ID:23821
FS_ID:63707
EP_NO: N/A
Repair Type: Non-Urgent
EVAL Issue: Unauthorized Encroachment, installed decades prior
Crossing Status: Found
UCIP Comments: 02/16/2021 Record was updated from No Action Needed to Non-Urgent. No permit was found authorizing this encroachment. CVFPB will need to review crossing to determine owner. Briar bush overgrowth limiting visual of WS toe. Working meter and control panel belonging Rancho San Joaquin Maintenance District Storm Water Facility at LS toe. LMA representative indicated utility belongs to the City of Stockton. The UCIP inspection was completed with DWR Inspector, O. Magana, and LMA representative, J. Caruso. (N. Cholewinski - GEI)
FIELD_STRUCT_DESC: [Rancho San Joaquin Maintenance District Storm Water Facility] 2 of 2: 10-inch soil proofed steel drainage pipe through the levee, 3 feet below the crown. Flap gate on the waterside (WS) end. Siphon breakers in a 24-inch corrugated metal riser unit on the WS shoulder. Pumps mounted over 6-foot by 7-foot concrete sump at the landside (LS) toe. [Additional Reference(s): DWR Levee Log, 1990. USACE San Joaquin O&M Manual 612.1, June 1965, (HLM 2.18)].

LS View: Pipe visible at LS toe. Electrical panel and post adjacent to pipe.

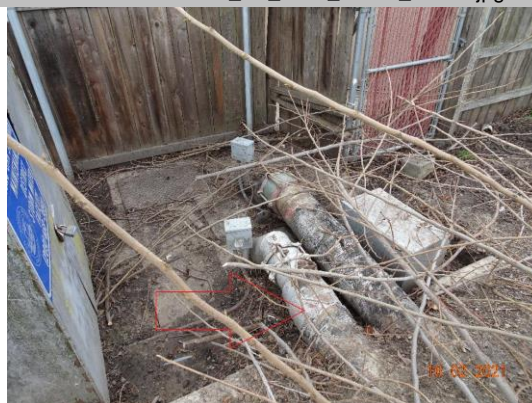
Photo 3 of 3 : UCIP_FA_2021_63707_93415.jpg

LS View: Pipe visible at LS toe. Electrical panel and post adjacent to pipe.

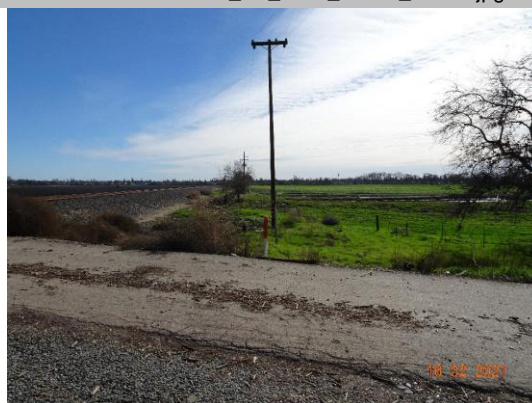
Photo 3 of 3 : UCIP_FA_2021_63745_93344.jpg

Comment Code						
Inspector Comment						
DS_ID:23734						
FS_ID:63745						
EP_NO: N/A						
Repair Type: Non-Urgent						
EVAL Issue: Unauthorized Encroachment, installed decades prior						
Crossing Status: Found						
UCIP Comments: 02/16/2021 Record was updated from No Action						
Needed to Non-Urgent. No permit was found authorizing this						
encroachment. CVFPB will need to review crossing to determine owner.						
DWR DMP has not found internal issues, LOF between 1 and 2.						
Recommend inspection in 5 years. Crack in headwall concrete visible						
on LS. Brush covering pipe opening on LS. Debris covering WS						
flapgate. The UCIP inspection was completed with DWR Inspector, O.						
Magana, and LMA representative, J. Caruso. (N. Cholewinski - GEI)						
FIELD_STRUCT_DESC: 24-inch corrugated metal drainage pipe						
through the levee, 7.4 feet below the crown. Concrete U-shaped						
headwalls on both ends. Flap gate on the waterside (WS) end. Cobble

grouted spillway across berm. [Additional Reference(s): DWR Levee						
Log, 1990. USACE San Joaquin O&M Manual 612.1, June 1965, (HLM						
3.73)].						
FS Date: 2/16/2021

LS View: Headwall at LS toe.

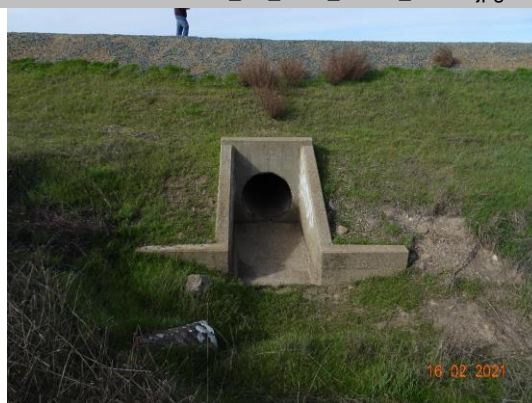
Photo 3 of 3 : UCIP_FA_2021_63749_93309.jpg

LS View: Headwall at LS toe.

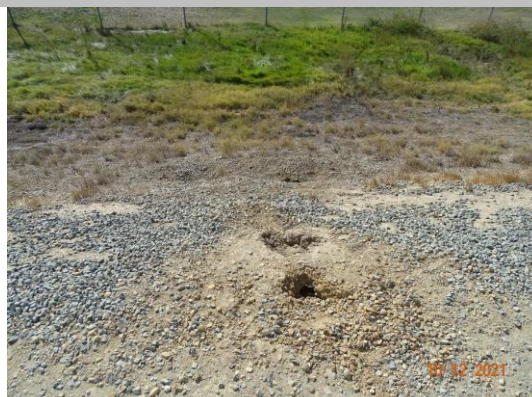
Photo 1 of 1 : FA_2021_NA0017_152_145_20211018_00418.jpg

LM Start	4.79	Rating **	U	Issue No.	145
LM End	4.79	Issue Type +	Ma	Location *	LS
Category	Earthen Levee			GPS Latitude/Longitude	
				Start	End
Item	Animal Control			38.043893 °	38.043893 °
				-121.296922 °	-121.296922 °
DWR ID	DWR_NA0017_08_f_2020_145				
Comment Code					
A3 : No rodents visible, but rodent burrows visible; need to backfill and compact or grout burrows.					
Inspector Comment

View of multiple rodent holes on landside slope. Fall 2021

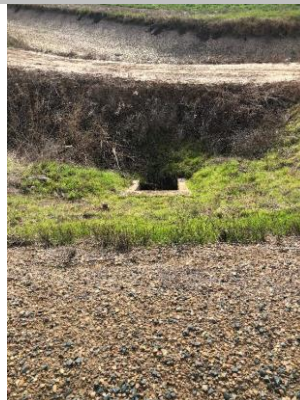
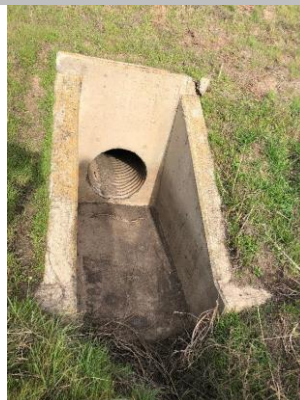
Comment Code						
Inspector Comment						
DS_ID:23709 FS_ID:63755 EP_NO: N/A Repair Type: Non-Urgent EVAL Issue: Unauthorized Encroachment, installed decades prior Crossing Status: Found UCIP Comments: 02/18/2021 Record was updated from No Action Needed to Non-Urgent. No permit was found authorizing this encroachment. CVFPB will need to review crossing to determine owner. DWR DMP has not found internal issues, LOF between 1 and 2. Recommend inspection in 5 years. LS pipe interior coating is weathering slightly. Small piece of concrete is broken off headwall on LS, not a integrity issue. The UCIP inspection was completed with DWR Inspector, S. Donovan, and LMA representative, J. Caruso. (N. Cholewinski - GEI) FIELD_STRUCT_DESC: 24-inch corrugated metal storm drainage pipe through the levee, 6.9 feet below the crown. Concrete U-shaped headwalls on both ends. Flap gate on the waterside (WS) end. Grouted intake on the landside (LS). Cobble grouted spillway across the berm. [Additional Reference(s): DWR Levee Log, 1990. USACE San Joaquin O&M Manual 612.1, June 1965, (HLM 5.69) and 612 (addendum), February 1999, (HLM 5.82) (Station 307+37)]. FS Date: 2/18/2021

LS View: Headwall at LS toe.

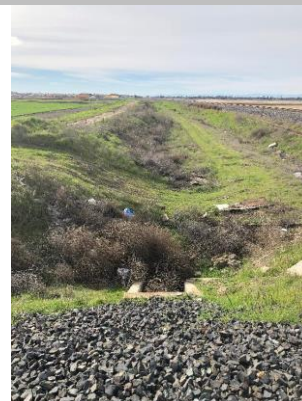
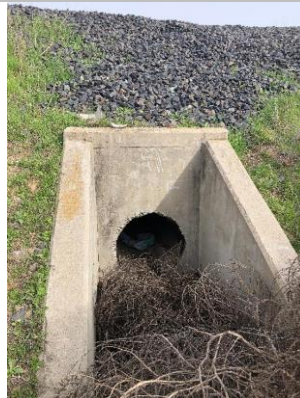
Comment Code					
Inspector Comment					
DS_ID:23711 FS_ID:63759 EP_NO: N/A Repair Type: Non-Urgent EVAL Issue: Unauthorized Encroachment, installed decades prior Crossing Status: Found UCIP Comments: 02/18/2021 Record was updated from No Action Needed to Non-Urgent. No permit was found authorizing this encroachment. CVFPB will need to review crossing to determine owner. DWR DMP has not found internal issues, LOF between 1 and 2. Recommend inspection in 5 years. Gravel observed above headwall on LS. The UCIP inspection was completed with DWR Inspector, S. Donovan, and LMA representative, J. Caruso. (N. Cholewinski - GEI) FIELD_STRUCT_DESC: 24-inch corrugated metal drainage pipe through the levee, 7.3 feet below the crown. Concrete U-shaped headwalls on both ends. Flap gate on the waterside (WS) end. Grouted intake on the landside (LS). Cobble grouted spillway across berm. [Additional Reference(s): DWR Levee Log, 1990. USACE San Joaquin O&M Manual 612.1, June 1965, (HLM 6.25)]. FS Date: 2/18/2021

LS View: Headwall at LS toe.
