**Flood Control Project Maintenance
Levee Inspections**

Maintenance Issue Types Only, Levee Inspection Report By Mile - Fall 2021

San Joaquin County Flood Control and Water Conservation District

Waterway	Bank	Unit Miles	Inspection Start/End	Inspector
Unit No. 01 Littlejohn Creek	Left	2.59	10/21/2021 10/21/2021	Alberto De Leon

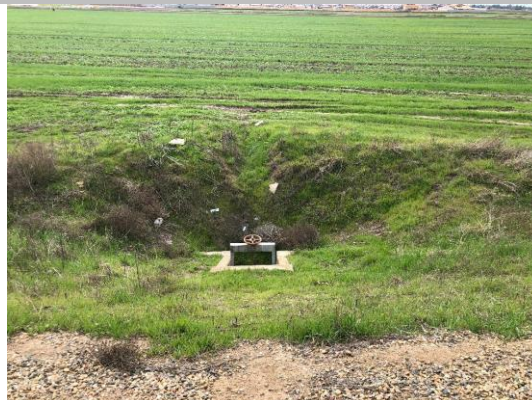
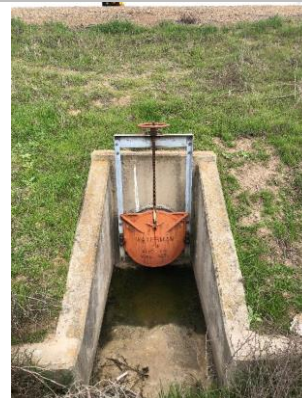
Comment Code					
Inspector Comment					
DS_ID:23713 FS_ID:63767 EP_NO: N/A Repair Type: Non-Urgent EVAL Issue: Pipe Damage Crossing Status: Found UCIP Comments: 02/18/2021 Pipe status is still Non-Urgent. DWR DMP has found integrity issues, LOF between 4 and 5. No permit was found authorizing this encroachment. CVFPB will need to review crossing to determine owner. The UCIP inspection was completed with DWR Inspector, S. Donovan, and LMA representative, J. Caruso. (N. Cholewinski - GEI)05/22/2014 Gate rusted shut on LS toe. (W. Wylie - DWR UCIP) FIELD_STRUCT_DESC: 24-inch corrugated metal storm drainage pipe through the levee, 7.9 feet below the crown. Concrete U-shaped headwalls on both ends. Flap gate on the waterside (WS) end. Slide gate on the landside (LS) end. Cobble grouted spillway across berm. [Additional Reference(s): DWR Levee Log, 1990. USACE San Joaquin O&M Manual 612.1, June 1965, (HLM 6.35) and 612 (addendum), February 1999, (HLM 6.36) (Station 335+70)]. FS Date: 2/18/2021

LS View: Headwall with slide gate at LS toe.

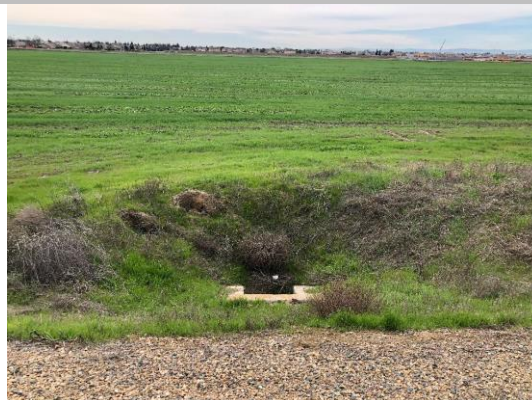
Photo 2 of 3 : UCIP_FA_2021_63769_93168.jpg

DS_ID:23714
 FS_ID:63769
 EP_NO: N/A
 Repair Type: Non-Urgent
 EVAL Issue: Unauthorized Encroachment, installed decades prior
 Crossing Status: Found
 UCIP Comments: 02/18/2021 Record was updated from No Action Needed to Non-Urgent. No permit was found authorizing this encroachment. CVFPB will need to review crossing to determine owner. DWR DMP has not found internal issues, LOF between 1 and 2. Recommend inspection in 5 years. Slight weathering of pipe interior coating at LS toe. The UCIP inspection was completed with DWR Inspector, S. Donovan, and LMA representative, J. Caruso. (N. Cholewinski - GEI)
 FIELD_STRUCT_DESC: 24-inch corrugated metal drainage pipe through the levee, 8.5 feet below the crown. Concrete U-shaped headwalls on both ends. Flap gate on the waterside (WS) end. Grouted intake on the landside (LS). Cobble grouted spillway across the berm. [Additional Reference(s): DWR Levee Log, 1990. USACE San Joaquin O&M Manual 612.1, June 1965, (HLM 6.56)].

LS View: Headwall at LS toe.

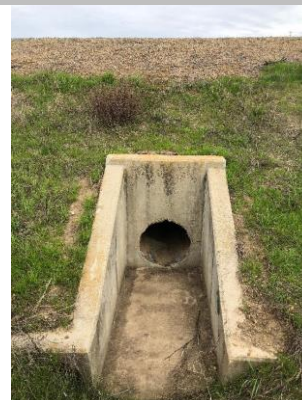
Photo 3 of 3 : UCIP_FA_2021_63769_93169.jpg

LS View: Headwall at LS toe.

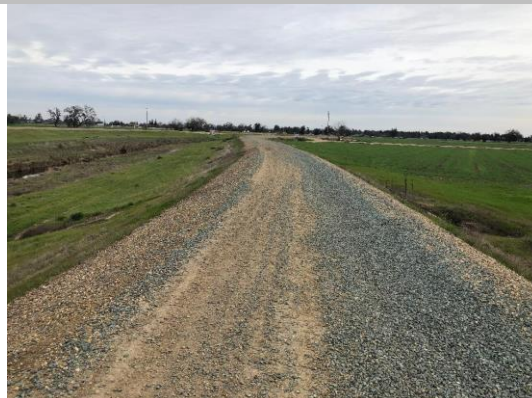
Photo 1 of 3 : UCIP_FA_2021_63770_93159.jpg

Comment Code						
Inspector Comment						
DS_ID:23715 FS_ID:63770 EP_NO: N/A Repair Type: Non-Urgent EVAL Issue: Unauthorized Encroachment, installed decades prior Crossing Status: Found UCIP Comments: 02/18/2021 Record was updated from No Action Needed to Non-Urgent. No permit was found authorizing this encroachment. CVFPB will need to review crossing to determine owner. DWR DMP has not found internal issues, LOF between 1 and 2. Recommend inspection in 5 years. Stiff WS flapgate, but still opens. Pipe bent and small gap observed at base of pipe at LS toe. The UCIP inspection was completed with DWR Inspector, S. Donovan, and LMA representative, J. Caruso. (N. Cholewinski - GEI) FIELD_STRUCT_DESC: 24-inch corrugated metal storm drainage pipe through the levee, 8 feet below the crown. Concrete U-shaped headwalls on both ends. Flap gate on the waterside (WS) end. Grouted intake on the landside (LS). Cobble grouted spillway across the berm. [Additional Reference(s): DWR Levee Log, 1990. USACE San Joaquin O&M Manual 612.1, June 1965, (HLM 6.72) and 612 (addendum), February 1999, (HLM 6.67) (Station 352+14)]. FS Date: 2/18/2021

Crown Overview

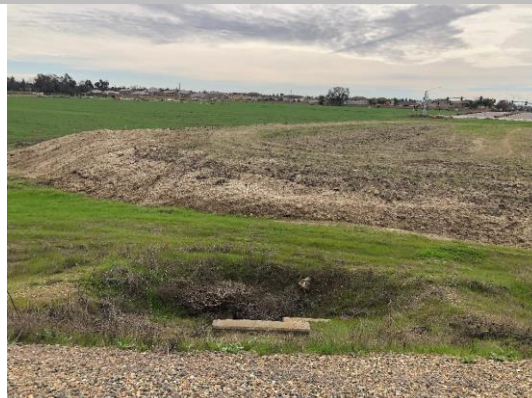
Photo 2 of 3 : UCIP_FA_2021_63770_93160.jpg

LS View: Headwall at LS toe.

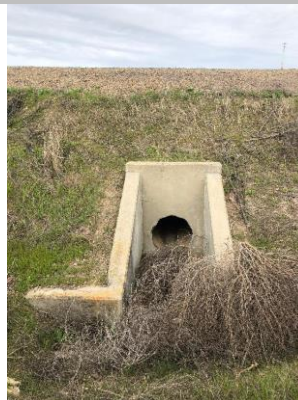
Photo 3 of 3 : UCIP_FA_2021_63770_93161.jpg

LS View: Headwall at LS toe.

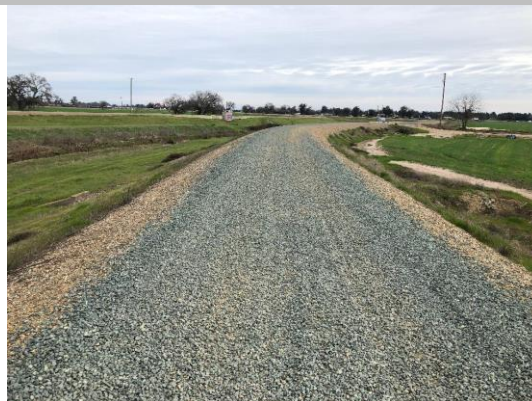
Photo 1 of 3 : UCIP_FA_2021_63771_93152.jpg

DS_ID:23716
FS_ID:63771
EP_NO: N/A
Repair Type: Non-Urgent
EVAL Issue: Unauthorized Encroachment, installed decades prior
Crossing Status: Found
UCIP Comments: 02/18/2021 Record was updated from No Action Needed to Non-Urgent. No permit was found authorizing this encroachment. CVFPB will need to review crossing to determine owner. DWR DMP has not found internal issues, LOF between 1 and 2. Recommend inspection in 5 years. The UCIP inspection was completed with DWR Inspector, S. Donovan, and LMA representative, J. Caruso. (N. Cholewinski - GEI)
FIELD_STRUCT_DESC: 24-inch corrugated metal storm drainage pipe through the levee, 7.7 feet below the crown. Concrete U-shaped headwalls on both ends. Flap gate on the waterside (WS) end. Grouted intake on the landside (LS). Cobble grouted spillway across berm.
[Additional Reference(s): DWR Levee Log, 1990. USACE San Joaquin O&M Manual 612.1, June 1965, (HLM 6.79) and 612 (addendum), February 1999, (HLM 6.82) (Station 360+08)].

Crown Overview

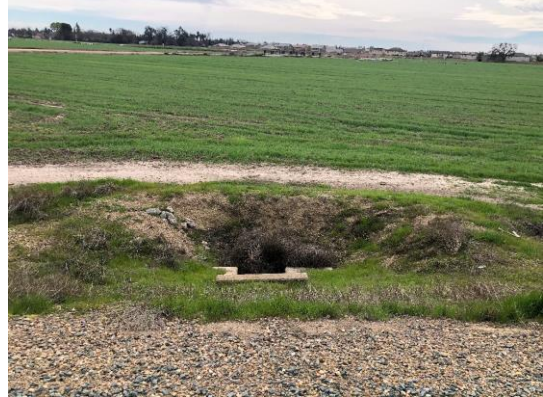
Photo 2 of 3 : UCIP_FA_2021_63771_93153.jpg

LS View: Headwall at LS toe.

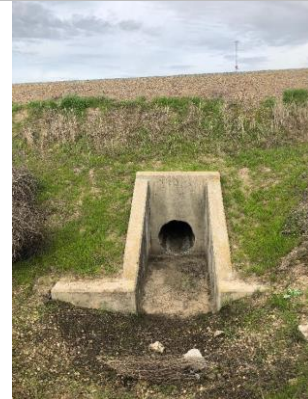
Photo 3 of 3 : UCIP_FA_2021_63771_93154.jpg

LS View: Headwall at LS toe.

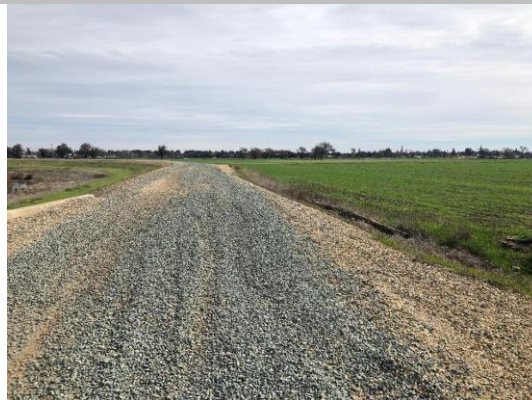
Photo 1 of 3 : UCIP_FA_2021_63773_93140.jpg

Comment Code						
Inspector Comment						
DS_ID:23718 FS_ID:63773 EP_NO: N/A Repair Type: Non-Urgent EVAL Issue: Unauthorized Encroachment, installed decades prior Crossing Status: Found UCIP Comments: 02/18/2021 Record was updated from No Action Needed to Non-Urgent. No permit was found authorizing this encroachment. CVFPB will need to review crossing to determine owner. DWR DMP has not found internal issues, LOF between 1 and 2. Recommend inspection in 5 years. Slight crumbling of concrete around pipe opening on LS. The UCIP inspection was completed with DWR Inspector, S. Donovan, and LMA representative, J. Caruso. (N. Cholewinski - GEI) FIELD_STRUCT_DESC: 24-inch corrugated metal storm drainage pipe through the levee, 6.5 feet below the crown. Concrete U-shaped headwalls on both ends. Flap gate on the waterside (WS) end. Grouted intake on the landside (LS). Cobble grouted spillway across the berm. [Additional Reference(s): DWR Levee Log, 1990. USACE San Joaquin O&M Manual 612.1, June 1965, (HLM 6.88) and 612 (addendum), February 1999, (HLM 6.89) (Station 363+76)]. FS Date: 2/18/2021

Crown Overview

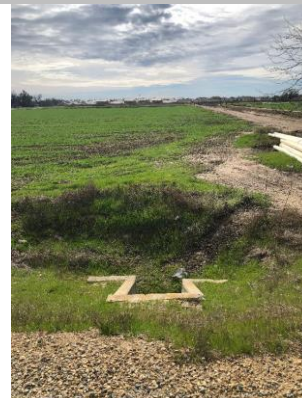
Photo 2 of 3 : UCIP_FA_2021_63773_93141.jpg

LS View: Headwall at LS toe.

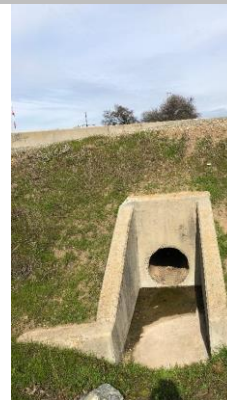
Photo 3 of 3 : UCIP_FA_2021_63773_93142.jpg

LS View: Headwall at LS toe.

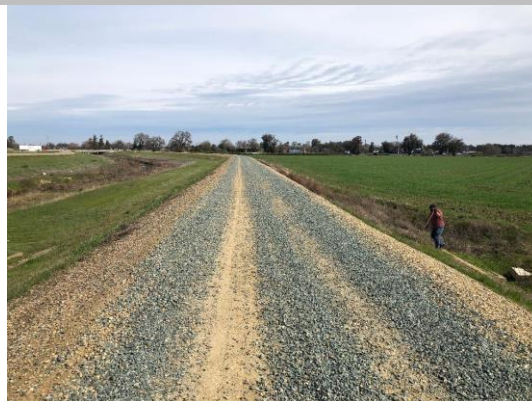
Photo 1 of 3 : UCIP_FA_2021_63775_93130.jpg

DS_ID:23719
 FS_ID:63775
 EP_NO: N/A
 Repair Type: Non-Urgent
 EVAL Issue: Unauthorized Encroachment, installed decades prior
 Crossing Status: Found
 UCIP Comments: 02/18/2021 Record was updated from No Action Needed to Non-Urgent. No permit was found authorizing this encroachment. CVFPB will need to review crossing to determine owner. DWR DMP has not found internal issues, LOF between 1 and 2. Recommend inspection in 5 years. The UCIP inspection was completed with DWR Inspector, S. Donovan, and LMA representative, J. Caruso. (N. Cholewinski - GEI)
 FIELD_STRUCT_DESC: 1 of 2: 30-inch corrugated metal storm drainage pipe through the levee, 8.3 feet below the crown. Concrete U-shaped headwalls on both ends. Flap gate on the waterside (WS) end. Grouted intake on the landside (LS). Cobble grouted spillway across the berm. [Additional Reference(s): DWR Levee Log, 1990. USACE San Joaquin O&M Manual 612.1, June 1965, (HLM 7.00) and 612 (addendum), February 1999, (HLM 7.10) (Station 374+70)].

Crown Overview

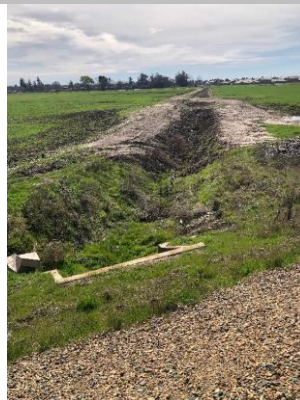
Photo 2 of 3 : UCIP_FA_2021_63775_93131.jpg

LS View: Headwall at LS toe.

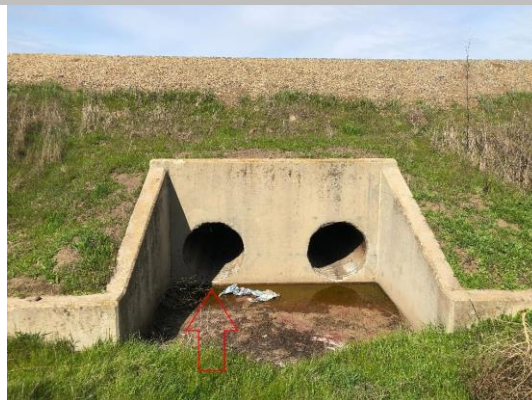
Photo 3 of 3 : UCIP_FA_2021_63775_93132.jpg

LS View: Headwall at LS toe.

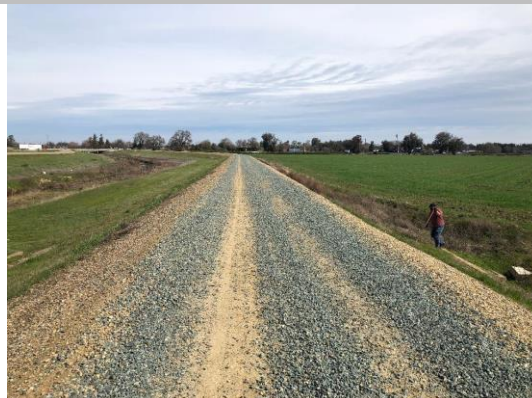
Photo 1 of 3 : UCIP_FA_2021_63776_93123.jpg

Comment Code						
Inspector Comment						
DS_ID:23812						
FS_ID:63776						
EP_NO: N/A						
Repair Type: Non-Urgent						
EVAL Issue: Unauthorized Encroachment, installed decades prior						
Crossing Status: Found						
UCIP Comments: 02/18/2021 Record was updated from No Action						
Needed to Non-Urgent. No permit was found authorizing this						
encroachment. CVFPB will need to review crossing to determine owner.						
DWR DMP has not found internal issues, LOF between 1 and 2.						
Recommend inspection in 5 years. The UCIP inspection was completed						
with DWR Inspector, S. Donovan, and LMA representative, J. Caruso.

(N. Cholewinski - GEI)						
FIELD_STRUCT_DESC: 2 of 2: 30-inch corrugated metal storm						
drainage pipe through the levee, 8.3 feet below the crown. Concrete U-						
shaped headwalls on both ends. Flap gate on the waterside (WS) end.						
Grouted intake on the landside (LS). Cobble grouted spillway across						
the berm. [Additional Reference(s): DWR Levee Log, 1990. USACE						
San Joaquin O&M Manual 612.1, June 1965, (HLM 7.00) and 612						
(addendum), February 1999, (HLM 7.10) (Station 374+70)].						
FS Date: 2/18/2021

Crown Overview

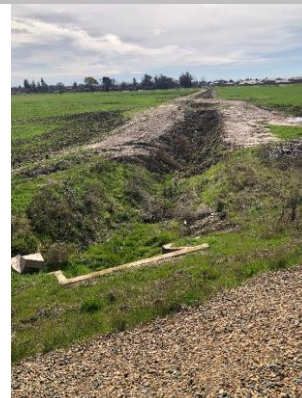
Photo 2 of 3 : UCIP_FA_2021_63776_93124.jpg

LS View: Headwall at LS toe.

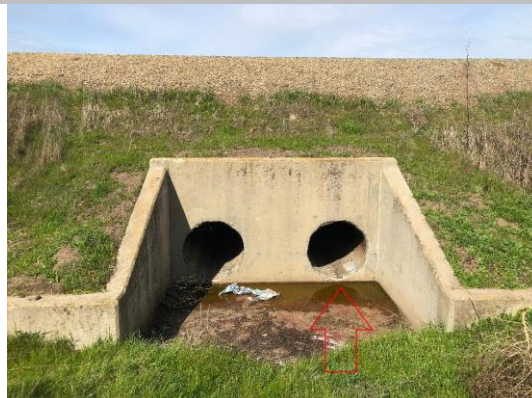
Photo 3 of 3 : UCIP_FA_2021_63776_93125.jpg

LS View: Headwall at LS toe.

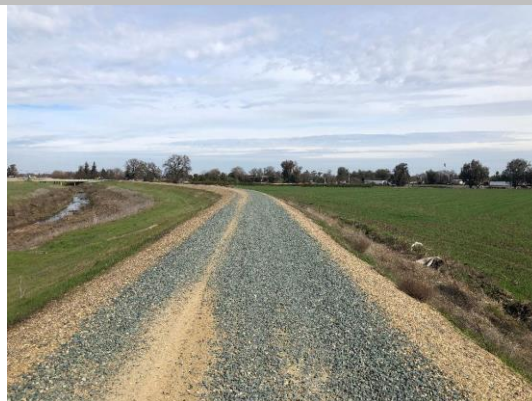
Photo 1 of 3 : UCIP_FA_2021_63777_93117.jpg

DS_ID:23720
FS_ID:63777
EP_NO: N/A
Repair Type: Non-Urgent
EVAL Issue: Unauthorized Encroachment, installed decades prior
Crossing Status: Found
UCIP Comments: 02/18/2021 Record was updated from No Action Needed to Non-Urgent. No permit was found authorizing this encroachment. CVFPB will need to review crossing to determine owner. DWR DMP has not found internal issues, LOF between 1 and 2. Recommend inspection in 5 years. The UCIP inspection was completed with DWR Inspector, S. Donovan, and LMA representative, J. Caruso. (N. Cholewinski - GEI)
FIELD_STRUCT_DESC: 36-inch corrugated metal storm drainage pipe through the levee, 6.5 feet below the crown. Concrete U-shaped headwalls on both ends. Flap gate on the waterside (WS) end. Grouted intake on the landside (LS). Cobble grouted spillway across berm.
[Additional Reference(s): DWR Levee Log, 1990. USACE San Joaquin O&M Manual 612.1, June 1965, (HLM 7.07) and 612 (addendum), February 1999, (HLM 7.18) (Station 379+00)].

Crown Overview

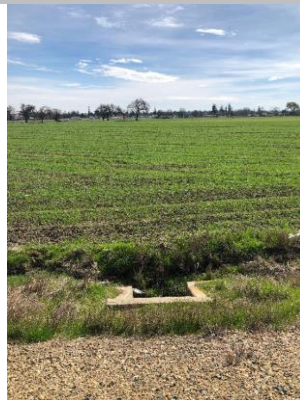
Photo 2 of 3 : UCIP_FA_2021_63777_93118.jpg

LS View: Headwall at LS toe.

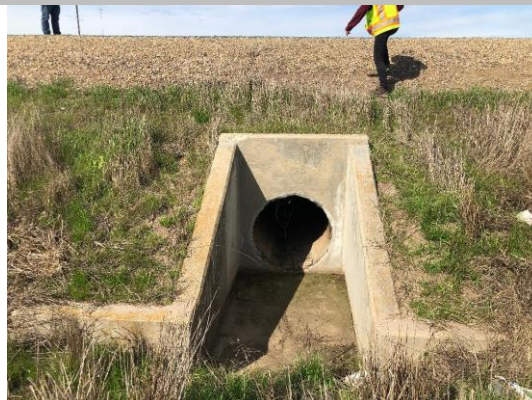
Photo 3 of 3 : UCIP_FA_2021_63777_93119.jpg

LS View: Headwall at LS toe.

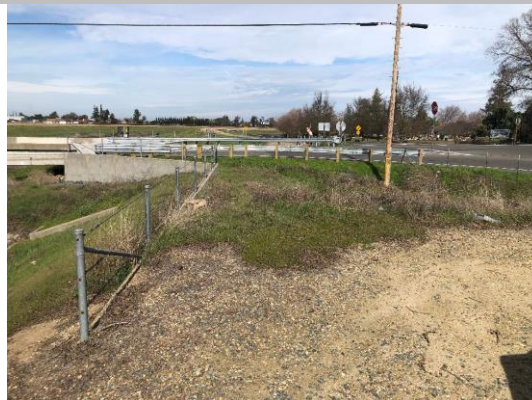
Photo 1 of 3 : UCIP_FA_2021_63778_93109.jpg

Comment Code						
Inspector Comment						
DS_ID:23721						
FS_ID:63778						
EP_NO: N/A						
Repair Type: Non-Urgent						
EVAL Issue: Unauthorized Encroachment, installed decades prior						
Crossing Status: Found						
UCIP Comments: 02/18/2021 Record was updated from No Action						
Needed to Non-Urgent. No permit was found authorizing this						
encroachment. CVFPB will need to review crossing to determine owner.						
DWR DMP has not found internal issues, LOF between 1 and 2.						
Recommend inspection in 5 years. The UCIP inspection was completed						
with DWR Inspector, S. Donovan, and LMA representative, J. Caruso.

Crown Overview

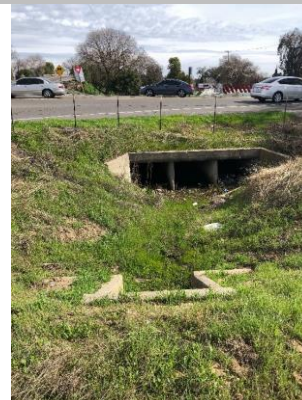
Photo 2 of 3 : UCIP_FA_2021_63778_93110.jpg

LS View: Headwall at LS toe.

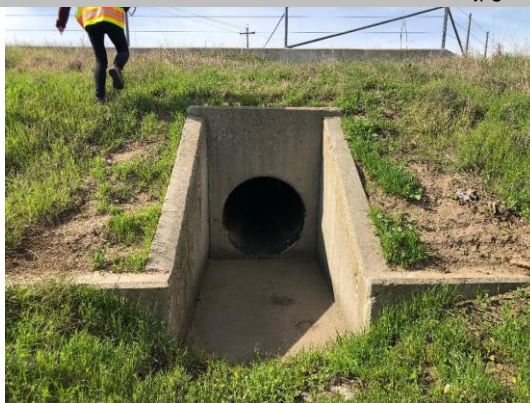
Photo 3 of 3 : UCIP_FA_2021_63778_93111.jpg

LS View: Headwall at LS toe.

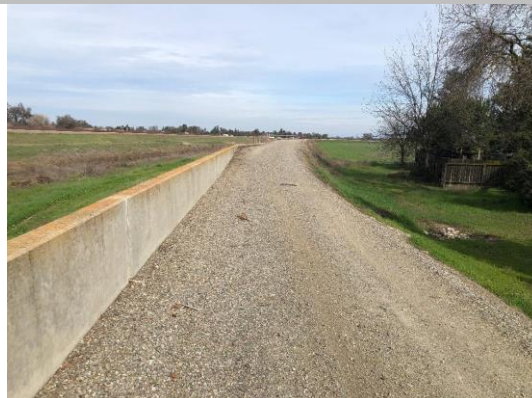
Photo 1 of 3 : UCIP_FA_2021_63783_93087.jpg

Comment Code						
Inspector Comment						
DS_ID:23743 FS_ID:63783 EP_NO: N/A Repair Type: Non-Urgent EVAL Issue: Unauthorized Encroachment, installed decades prior Crossing Status: Found UCIP Comments: 02/18/2021 Record remains Non-Urgent. No permit was found authorizing this encroachment. CVFPB will need to review crossing to determine owner. DWR DMP has not found internal issues, LOF between 1 and 2. Recommend inspection in 5 years. No cobbles observed in pipe at LS toe. The UCIP inspection was completed with DWR Inspector, S. Donovan, and LMA representative, J. Caruso. (N. Cholewinski - GEI)05/21/2014 Cobbles building up at inlet and inside pipe along with sediment. (W. Wylie - DWR UCIP) FIELD_STRUCT_DESC: 24-inch corrugated metal storm drainage pipe through the levee, 7 feet below the crown. Flap gate on the waterside (WS) end. Concrete U-shaped headwalls on both ends. Cobble grouted spillway across the berm. Cobble grouted apron on the landside (LS) end. [Additional Reference(s): DWR Levee Log, 1990. USACE San Joaquin O&M Manual 612.2, 1967, (HLM 7.65) and 612 (addendum), February 1999, (HLM 7.70) (Station 406+58)]. FS Date: 2/18/2021

Crown Overview

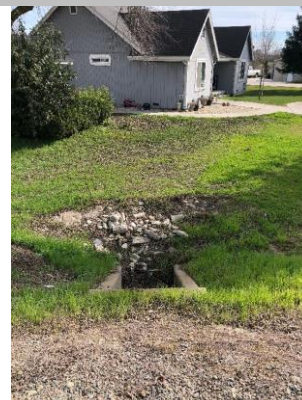
Photo 2 of 3 : UCIP_FA_2021_63783_93088.jpg

LS View: Headwall at LS toe.

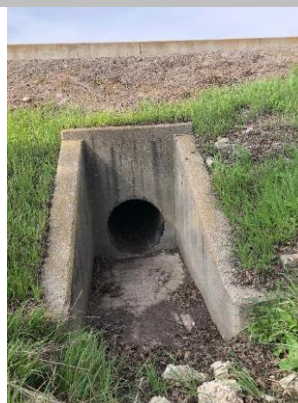
Photo 3 of 3 : UCIP_FA_2021_63783_93089.jpg

LS View: Headwall at LS toe.

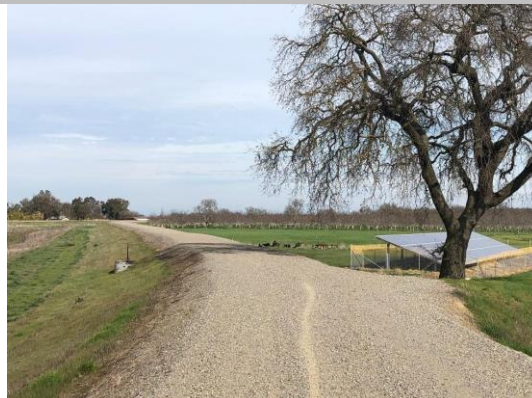
Photo 1 of 3 : UCIP_FA_2021_63784_93078.jpg

Comment Code						
Inspector Comment						
DS_ID:23744 FS_ID:63784 EP_NO: N/A Repair Type: Non-Urgent EVAL Issue: Safety Issue Crossing Status: Found UCIP Comments: 02/18/2021 Record remains Non-Urgent. No permit was found authorizing this encroachment. CVFPB will need to review crossing to determine owner. DWR DMP has not found internal issues, LOF between 1 and 2. Recommend inspection in 5 years. No lid on riser. Recommend adding lid to riser as a safety measure. The UCIP inspection was completed with DWR Inspector, S. Donovan, and LMA representative, J. Caruso. (N. Cholewinski - GEI)05/21/2014 Lid damaged/missing from CMP riser on WS slope. (W. Wylie - DWR UCIP) FIELD_STRUCT_DESC: 1 of 2: 36-inch corrugated metal storm drainage pipe through the levee, 9 feet below the crown. Flap gate on the waterside (WS) end. Slide gate in 48-inch corrugated metal riser unit on the WS slope. Concrete U-shaped headwalls on both ends. Cobble grouted spillway on the channel bank. Cobble grouted apron in ditch on the landside (LS). [Additional Reference(s): DWR Levee Log, 1990. USACE San Joaquin O&M Manual 612.2, 1967, (HLM 8.18) and 612 (addendum), February 1999, (HLM 8.21) (Station 433+70)]. FS Date: 2/18/2021

Crown Overview

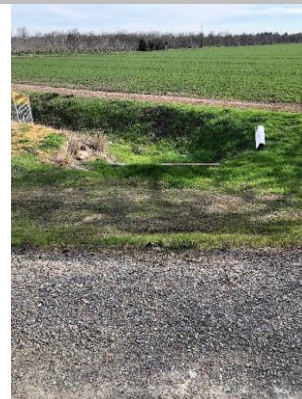
Photo 2 of 3 : UCIP_FA_2021_63784_93079.jpg

LS View: Headwall at LS toe.

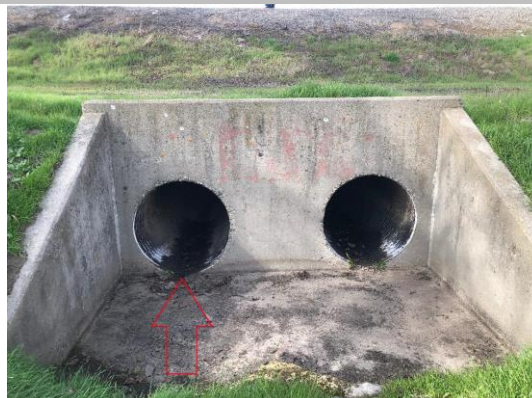
Photo 3 of 3 : UCIP_FA_2021_63784_93080.jpg

LS View: Headwall at LS toe.

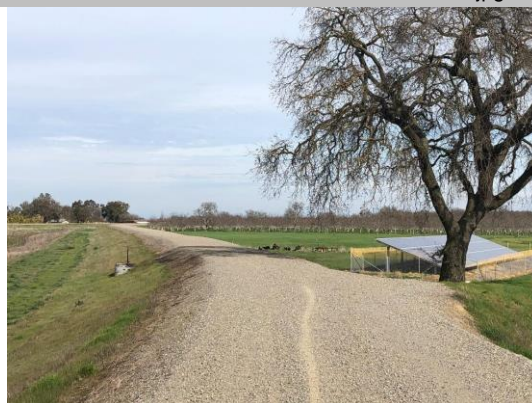
Photo 1 of 3 : UCIP_FA_2021_63785_93069.jpg

DS_ID:23820
FS_ID:63785
EP_NO: N/A
Repair Type: Non-Urgent
EVAL Issue: Safety Issue
Crossing Status: Found
UCIP Comments: 02/18/2021 Record remains Non-Urgent. No permit was found authorizing this encroachment. CVFPB will need to review crossing to determine owner. DWR DMP has not found internal issues, LOF between 1 and 2. Recommend inspection in 5 years. No lid on riser. Recommend adding lid to riser as a safety measure. The UCIP inspection was completed with DWR Inspector, S. Donovan, and LMA representative, J. Caruso. (N. Cholewinski - GEI)05/21/2014 Lid damaged/missing on 48-inch CMP riser on WS slope. (W. Wylie - DWR UCIP)
FIELD_STRUCT_DESC: 2 of 2: 36-inch corrugated metal storm drainage pipe through the levee, 9 feet below the crown. Flap gate on the waterside (WS) end. Slide gate in corrugated metal riser units on the WS slope. Concrete U-shaped headwalls on both ends. Cobble grouted spillway on the channel bank. Cobble grouted apron in ditch on the landside (LS). [Additional Reference(s): DWR Levee Log, 1990. USACE San Joaquin O&M Manual 612.2, 1967, (HLM 8.18) and 612 (addendum), February 1999, (HLM 8.21) (Station 433+70)].

Crown Overview

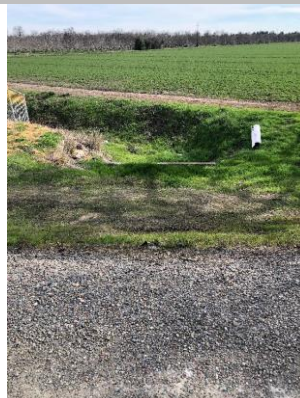
Photo 2 of 3 : UCIP_FA_2021_63785_93070.jpg

LS View: Headwall at LS toe.

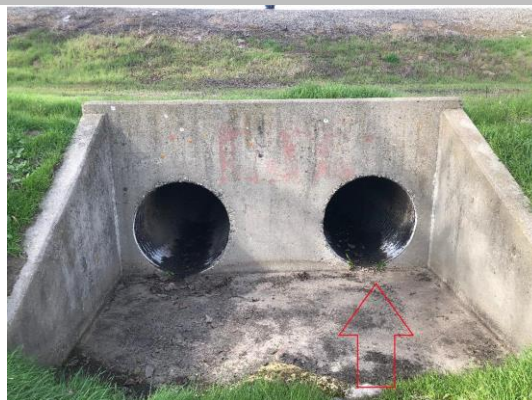
Photo 3 of 3 : UCIP_FA_2021_63785_93071.jpg

LS View: Headwall at LS toe.

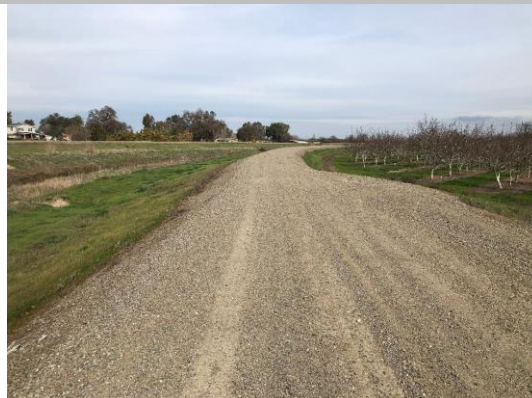
Photo 1 of 3 : UCIP_FA_2021_63786_93054.jpg

Comment Code						
Inspector Comment						
DS_ID:23745 FS_ID:63786 EP_NO: N/A Repair Type: Non-Urgent EVAL Issue: Unauthorized Encroachment, installed decades prior Crossing Status: Found UCIP Comments: 02/18/2021 Record was updated from No Action Needed to Non-Urgent. No permit was found authorizing this encroachment. CVFPB will need to review crossing to determine owner. DWR DMP has not found internal issues, LOF between 1 and 2. Recommend inspection in 5 years. The UCIP inspection was completed with DWR Inspector, S. Donovan, and LMA representative, J. Caruso. (N. Cholewinski - GEI) FIELD_STRUCT_DESC: 24-inch corrugated metal storm drainage pipe through the levee, 7 feet below the crown. Flap gate on the waterside (WS) end. Concrete U-shaped headwalls on both ends. Cobble grouted spillway across the berm. Cobble grouted apron on the landside (LS) end. [Additional Reference(s): DWR Levee Log, 1990. USACE San Joaquin O&M Manual 612.2, 1967, (HLM 8.34) and 612 (addendum), February 1999, (HLM 8.37) (Station 442+14)]. FS Date: 2/18/2021

Crown Overview

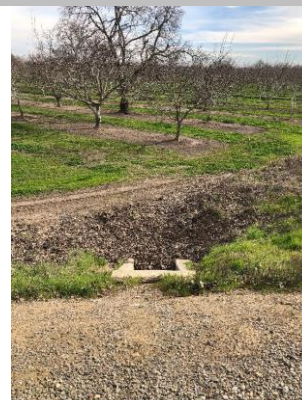
Photo 2 of 3 : UCIP_FA_2021_63786_93055.jpg

LS View: Headwall at LS toe.

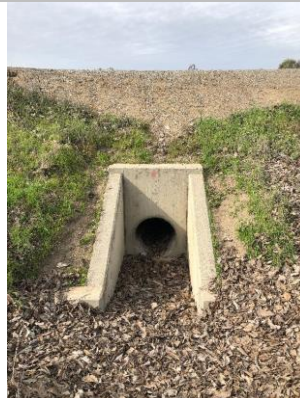
Photo 3 of 3 : UCIP_FA_2021_63786_93056.jpg

LS View: Headwall at LS toe.

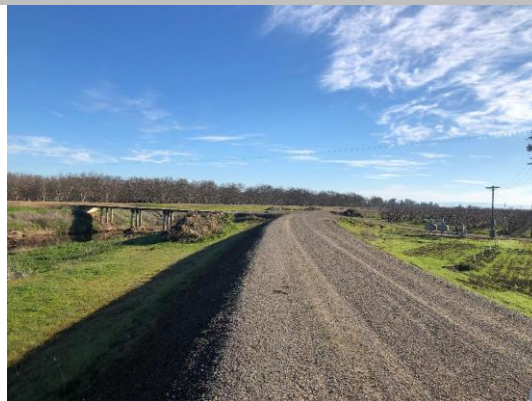
Photo 1 of 3 : UCIP_FA_2021_63790_93021.jpg

DS_ID:23722
 FS_ID:63790
 EP_NO: N/A
 Repair Type: Non-Urgent
 EVAL Issue: Unauthorized Encroachment, installed decades prior
 Crossing Status: Found
 UCIP Comments: 02/22/2021 Record was updated from No Action Needed to Non-Urgent. No permit was found authorizing this encroachment. CVFPB will need to review crossing to determine owner. DWR DMP has not found internal issues, LOF between 1 and 2. Recommend inspection in 5 years. The UCIP inspection was completed with DWR Inspector, S. Donovan, and LMA representative, J. Caruso. (N. Cholewinski - GEI)
 FIELD_STRUCT_DESC: 24-inch corrugated metal storm drainage pipe through the levee, 5.5 feet below the crown. Flap gate on the waterside (WS) end. Concrete U-shaped headwalls on both ends. Cobble grouted spillway across berm. Cobble grouted apron on the landside (LS) end.
 [Additional Reference(s): DWR Levee Log, 1990. USACE San Joaquin O&M Manual 612.2, 1967, (HLM 9.52) and 612 (addendum), February 1999, (HLM 9.52) (Station 502+83)].

Crown Overview

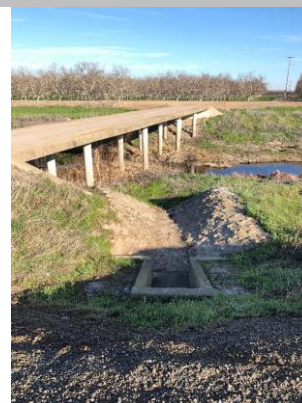
Photo 2 of 3 : UCIP_FA_2021_63790_93022.jpg

WS View: Headwall and flapgate at WS slope.

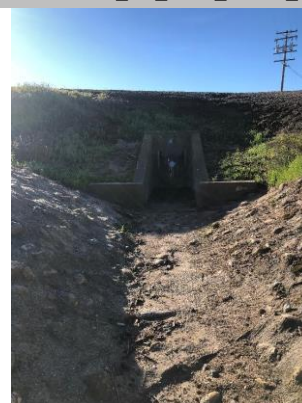
Photo 3 of 3 : UCIP_FA_2021_63790_93023.jpg

WS View: Headwall and flapgate at WS slope.

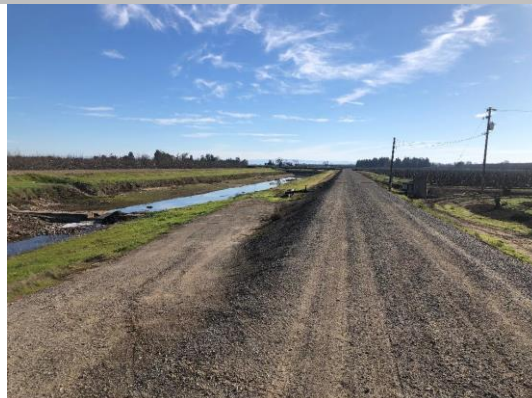
Photo 1 of 3 : UCIP_FA_2021_63292_92901.jpg

Comment Code						
Inspector Comment						
DS_ID:23726 FS_ID:63292 EP_NO: N/A Repair Type: Non-Urgent EVAL Issue: Pipe Damage Crossing Status: Found UCIP Comments: 02/22/2021 Record was updated from No Action Needed to Non-Urgent. DWR DMP has found integrity issues, LOF between 4 and 5. Crossing will be monitored until funding becomes available for rehabilitation. No permit was found authorizing this encroachment. CVFPB will need to review crossing to determine owner. Approximately 7 bullet holes observed in WS flapgate. The UCIP inspection was completed with DWR Inspector, S. Donovan, and LMA representative, J. Caruso. (N. Cholewinski - GEI) FIELD_STRUCT_DESC: 24-inch corrugated metal storm drainage pipe through the levee, 8.5 feet below the crown. Flap gate on the waterside (WS) end. Concrete U-shaped headwalls on both ends. Cobble grouted spillway across berm. Cobble grouted apron on the landside (LS) end. [Additional Reference(s): DWR Levee Log, 1990. USACE San Joaquin O&M Manual 612.2, 1967, (HLM 9.85) and 612 (addendum), February 1999, (HLM 9.76) (Station 515+23)]. FS Date: 2/22/2021

Crown Overview

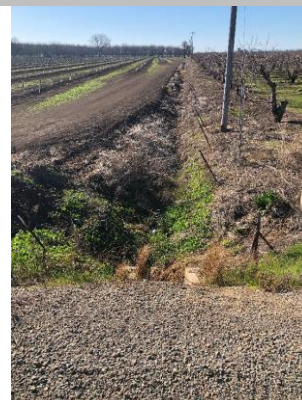
Photo 2 of 3 : UCIP_FA_2021_63292_92902.jpg

LS View: Headwall at LS toe.

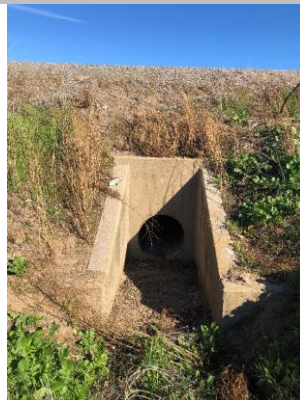
Photo 3 of 3 : UCIP_FA_2021_63292_92910.jpg

LS View: Headwall at LS toe.

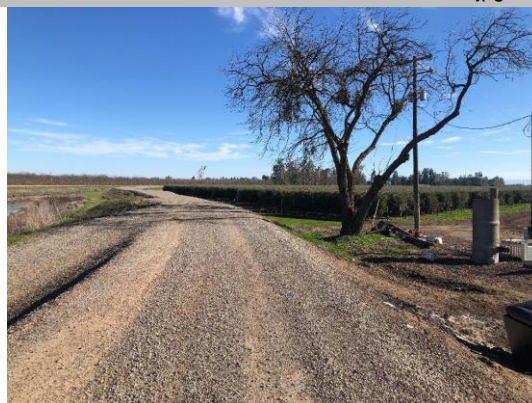
Photo 1 of 3 : UCIP_FA_2021_63793_92888.jpg

DS_ID:23727
 FS_ID:63793
 EP_NO: N/A
 Repair Type: Non-Urgent
 EVAL Issue: Unauthorized Encroachment, installed decades prior
 Crossing Status: Found
 UCIP Comments: 02/22/2021 Pipe status is still Non-Urgent. No permit was found authorizing this encroachment. CVFPB will need to review crossing to determine owner. DWR DMP has not found internal issues, LOF between 1 and 2. Recommend inspection in 5 years. Slope above WS headwall is very steep and eroding. Sediment from erosion observed on top of WS pipe outlet. Sediment build-up has decreased in pipe at LS toe. The UCIP inspection was completed with DWR Inspector, S. Donovan, and LMA representative, J. Caruso. (N. Cholewinski - GEI)05/21/2014 Sediment and debris buildup inside pipe on LS toe. (W. Wylie - DWR UCIP)
 FIELD_STRUCT_DESC: 24-inch corrugated metal storm drainage pipe through the levee, 7 feet below the crown. Flap gate on the waterside (WS) end. Concrete U-shaped headwalls on both ends. Cobble grouted spillway across the berm. Cobble grouted apron on the landside (LS) end. [Additional Reference(s): DWR Levee Log, 1990. USACE San Joaquin O&M Manual 612.2, 1967, (HLM 10.09) and 612 (addendum), February 1999, (HLM 10.00) (Station 528+18)].

Crown Overview

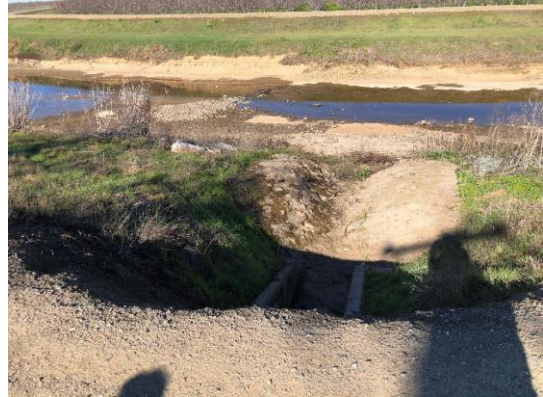
Photo 2 of 3 : UCIP_FA_2021_63793_92889.jpg

WS View: Headwall and flapgate on WS slope.

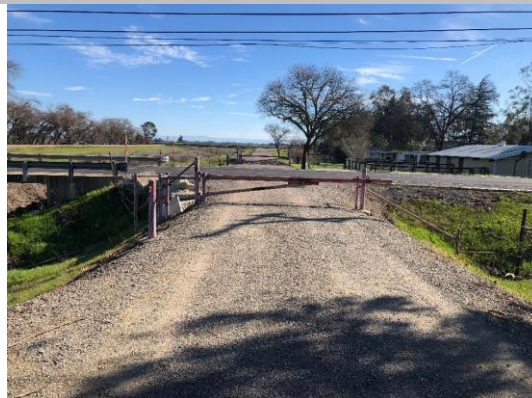
Photo 1 of 3 : UCIP_FA_2021_63794_92857.jpg

Comment Code						
Inspector Comment						
DS_ID:23728 FS_ID:63794 EP_NO: N/A Repair Type: Non-Urgent EVAL Issue: Unauthorized Encroachment, installed decades prior Crossing Status: Found UCIP Comments: 02/22/2021 Record was updated from No Action Needed to Non-Urgent. No permit was found authorizing this encroachment. CVFPB will need to review crossing to determine owner. DWR DMP has not found internal issues, LOF between 1 and 2. Recommend inspection in 5 years. Some concrete rubble observed above headwall on WS. The UCIP inspection was completed with DWR Inspector, S. Donovan, and LMA representative, J. Caruso. (N. Cholewinski - GEI) FIELD_STRUCT_DESC: 24-inch corrugated metal storm drainage pipe through the levee, 9 feet below the crown. Flap gate on the waterside (WS) end. Concrete U-shaped headwalls on both ends. Cobble grouted spillway across berm. Cobble grouted apron on the landside (LS) end. [Additional Reference(s): DWR Levee Log, 1990. USACE San Joaquin O&M Manual 612.2, 1967, (HLM 10.46) and 612 (addendum), February 1999, (HLM 10.44) (Station 551+22)]. FS Date: 2/22/2021

Crown Overview

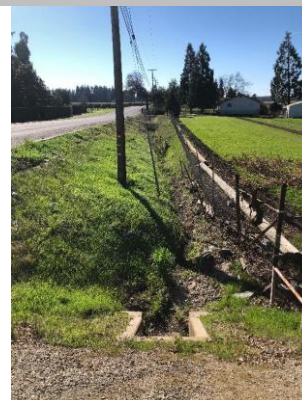
Photo 2 of 3 : UCIP_FA_2021_63794_92859.jpg

LS View: Headwall at LS toe.

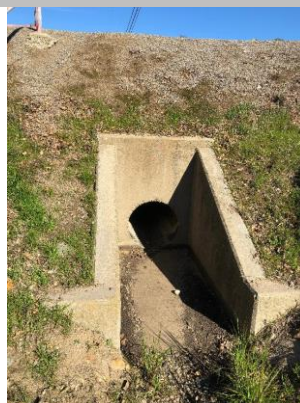
Photo 3 of 3 : UCIP_FA_2021_63794_92864.jpg

LS View: Facing headwall at LS toe.

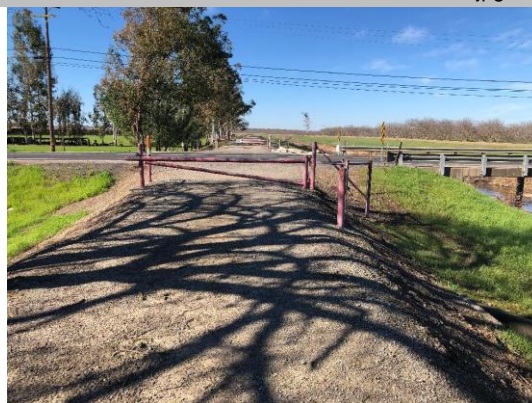
Photo 1 of 3 : UCIP_FA_2021_63795_92828.jpg

DS_ID:23729
FS_ID:63795
EP_NO: N/A
Repair Type: Non-Urgent
EVAL Issue: Unauthorized Encroachment, installed decades prior
Crossing Status: Found
UCIP Comments: 02/22/2021 Pipe status is still Non-Urgent. No permit was found authorizing this encroachment. CVFPB will need to review crossing to determine owner. DWR DMP has not found internal issues, LOF between 1 and 2. Recommend inspection in 5 years. Water observed at pipe opening at LS toe. The UCIP inspection was completed with DWR Inspector, S. Donovan, and LMA representative, J. Caruso. (N. Cholewinski - GEI)05/21/2014 Some sediment buildup in pipe at LS toe. (W. Wylie - DWR UCIP)
FIELD_STRUCT_DESC: 24-inch corrugated metal storm drainage pipe through the levee, 7 feet below the crown. Flap gate on the waterside (WS) end. Concrete U-shaped headwalls on both ends. Cobble grouted spillway across the berm. Cobble grouted apron on the landside (LS) end. [Additional Reference(s): DWR Levee Log, 1990. USACE San Joaquin O&M Manual 612.2, 1967, (HLM 10.48) and 612 (addendum), February 1999, (HLM 10.46) (Station 552+17)].

Crown Overview

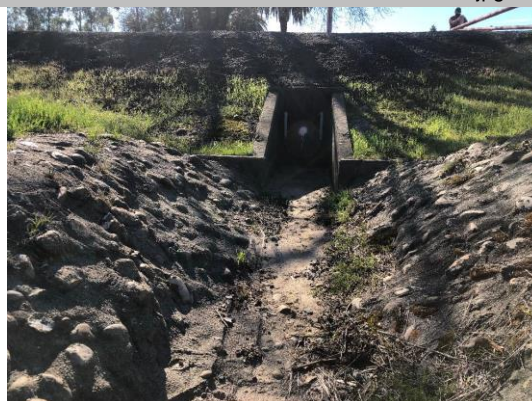
Photo 2 of 3 : UCIP_FA_2021_63795_92829.jpg

WS View: Headwall and flapgate at WS slope.

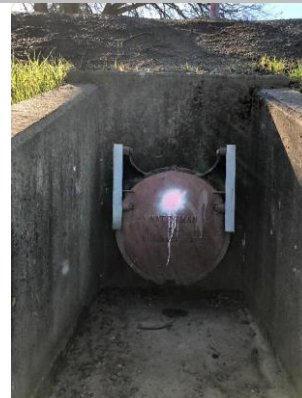
Photo 3 of 3 : UCIP_FA_2021_63795_92830.jpg

WS View: Headwall and 24-inch flapgate at WS slope.

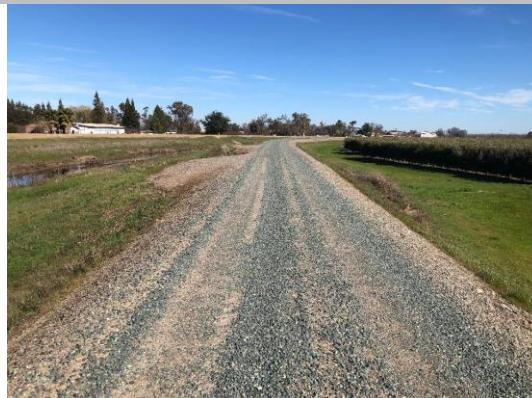
Photo 1 of 3 : UCIP_FA_2021_63839_92810.jpg

Comment Code						
Inspector Comment						
DS_ID:23748 FS_ID:63839 EP_NO: N/A Repair Type: Non-Urgent EVAL Issue: Unauthorized Encroachment, installed decades prior Crossing Status: Found UCIP Comments: 02/22/2021 Record was updated from No Action Needed to Non-Urgent. No permit was found authorizing this encroachment. CVFPB will need to review crossing to determine owner. DWR DMP has not found internal issues, LOF between 1 and 2. Recommend inspection in 5 years. 4.5-inch PVC pipe discharging at LS toe headwall. 2-inch PVC pipe on LS slope adjacent to headwall, seems disconnected. The UCIP inspection was completed with DWR Inspector, S. Donovan, and LMA representative, J. Caruso. (N. Cholewinski - GEI)05/21/2014 2-small PVC pipes discharge into inlet on LS toe. (W. Wylie - DWR UCIP) FIELD_STRUCT_DESC: 24-inch corrugated metal storm drainage pipe through the levee, 7 feet below the crown. Flap gate on the waterside (WS) end. Concrete U-shaped headwalls on both ends. Cobble grouted spillway across the berm. Cobble grouted apron on the landside (LS) end. [Additional Reference(s): DWR Levee Log, 1990. USACE San Joaquin O&M Manual 612.2, 1967, (HLM 10.75) and 612 (addendum), February 1999, (HLM 10.72) (Station 566+09)]. FS Date: 2/22/2021

Crown Overview

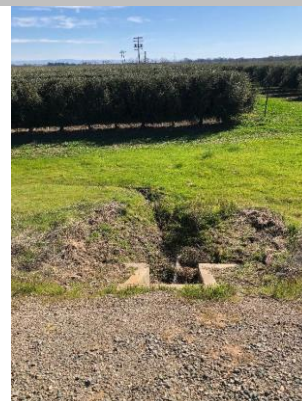
Photo 2 of 3 : UCIP_FA_2021_63839_92811.jpg

LS View: Headwall at LS toe.

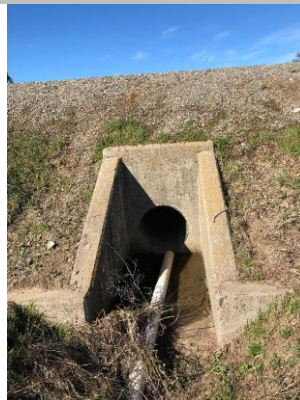
Photo 3 of 3 : UCIP_FA_2021_63839_92812.jpg

LS View: Headwall at LS toe. 4.5-inch PVC pipe discharges at headwall.

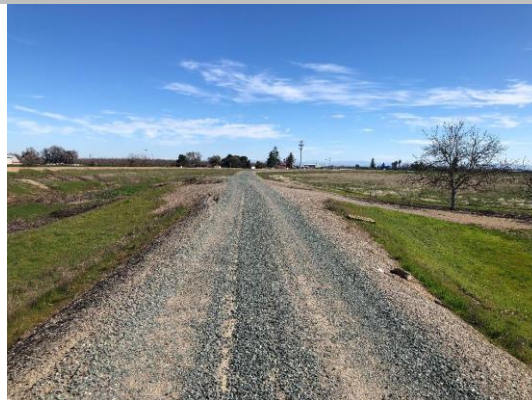
Photo 1 of 3 : UCIP_FA_2021_63796_92787.jpg

Comment Code						
Inspector Comment						
DS_ID:23749 FS_ID:63796 EP_NO: N/A Repair Type: Non-Urgent EVAL Issue: Unauthorized Encroachment, installed decades prior Crossing Status: Found UCIP Comments: 02/22/2021 Pipe status is still Non-Urgent. No permit was found authorizing this encroachment. CVFPB will need to review crossing to determine owner. DWR DMP has not found internal issues, LOF between 1 and 2. Recommend inspection in 5 years. The UCIP inspection was completed with DWR Inspector, S. Donovan, and LMA representative, J. Caruso. (N. Cholewinski - GEI)05/21/2014 Some silt buildup in pipe at LS toe. (W. Wylie - DWR UCIP) FIELD_STRUCT_DESC: 24-inch corrugated metal storm drainage pipe through the levee, 8 feet below the crown. Flap gate on the waterside (WS) end. Concrete U-shaped headwalls on both ends. Cobble grouted spillway across the berm. Cobble grouted apron on the landside (LS) end. [Additional Reference(s): DWR Levee Log, 1990. USACE San Joaquin O&M Manual 612.2, 1967, (HLM 10.97) and 612 (addendum), February 1999, (HLM 10.94) (Station 577+59)]. FS Date: 2/22/2021

Crown Overview

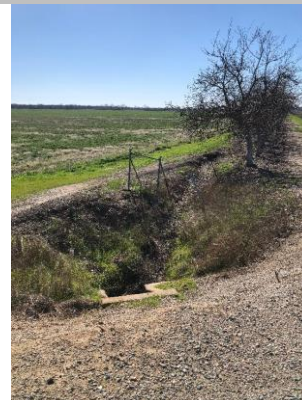
Photo 2 of 3 : UCIP_FA_2021_63796_92788.jpg

LS View: Headwall at LS toe.

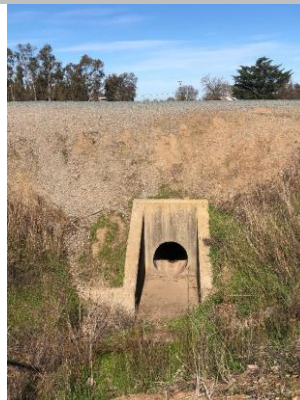
Photo 3 of 3 : UCIP_FA_2021_63796_92789.jpg

LS View: Headwall at LS toe.

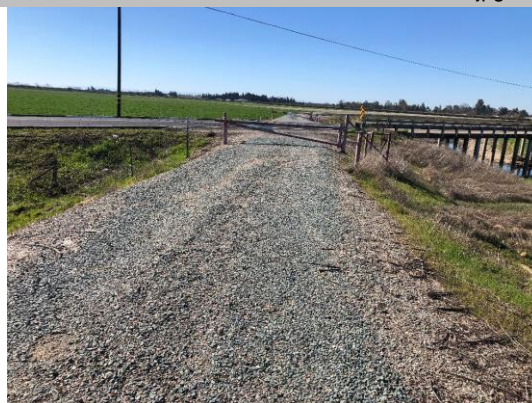
Photo 1 of 3 : UCIP_FA_2021_63797_92755.jpg

DS_ID:23750
FS_ID:63797
EP_NO: N/A
Repair Type: Non-Urgent
EVAL Issue: Unauthorized Encroachment, installed decades prior
Crossing Status: Found
UCIP Comments: 02/22/2021 Record was updated from No Action Needed to Non-Urgent. No permit was found authorizing this encroachment. CVFPB will need to review crossing to determine owner. DWR DMP has not completed an internal inspection of the pipe. The UCIP inspection was completed with DWR Inspector, S. Donovan, and LMA representative, J. Caruso. (N. Cholewinski - GEI)
FIELD_STRUCT_DESC: 24-inch corrugated metal storm drainage pipe through the levee, 7 feet below the crown. Concrete U-shaped headwalls on both ends. Cobble grouted spillway across the berm. Cobble grouted apron on the landside (LS). [Additional Reference(s): DWR Levee Log, 1990. USACE San Joaquin O&M Manual 612.2, 1967, (HLM 11.32) and 612 (addendum), February 1999, (HLM 11.28) (Station 595+39)].

Crown Overview

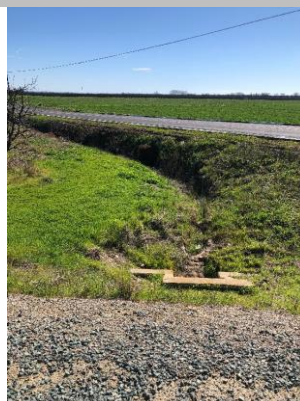
Photo 2 of 3 : UCIP_FA_2021_63797_92763.jpg

LS View: Headwall at LS toe.

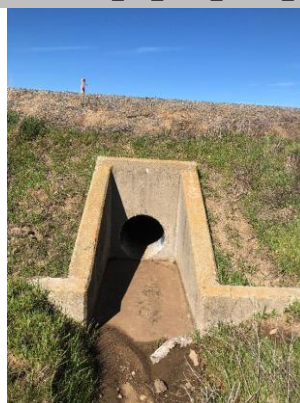
Photo 3 of 3 : UCIP_FA_2021_63797_92764.jpg

LS View: Headwall at LS toe.

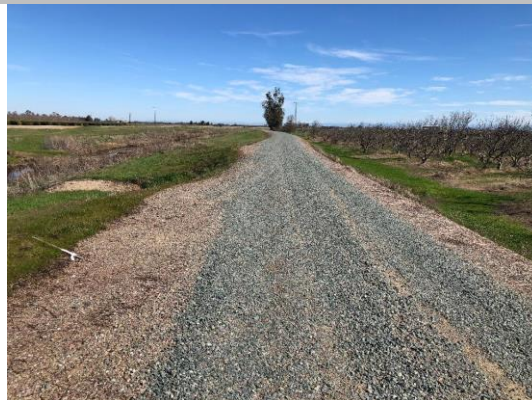
Photo 1 of 3 : UCIP_FA_2021_63798_92742.jpg

Comment Code						
Inspector Comment						
DS_ID:23751 FS_ID:63798 EP_NO: N/A Repair Type: Non-Urgent EVAL Issue: Unauthorized Encroachment, installed decades prior Crossing Status: Found UCIP Comments: 02/22/2021 Record was updated from No Action Needed to Non-Urgent. No permit was found authorizing this encroachment. CVFPB will need to review crossing to determine owner. DWR DMP has not found internal issues, LOF between 1 and 2. Recommend inspection in 5 years. The UCIP inspection was completed with DWR Inspector, S. Donovan, and LMA representative, J. Caruso. (N. Cholewinski - GEI) FIELD_STRUCT_DESC: 36-inch corrugated metal storm drainage pipe through the levee, 7.5 feet below the crown. Flap gate on the waterside (WS) end. Concrete U-shaped headwalls on both ends. Cobble grouted spillway across the berm. Cobble grouted apron on the landside (LS) end. [Additional Reference(s): DWR Levee Log, 1990. USACE San Joaquin O&M Manual 612.2, 1967, (HLM 11.37) and 612 (addendum), February 1999, (HLM 11.32) (Station 597+78)]. FS Date: 2/22/2021

Crown Overview

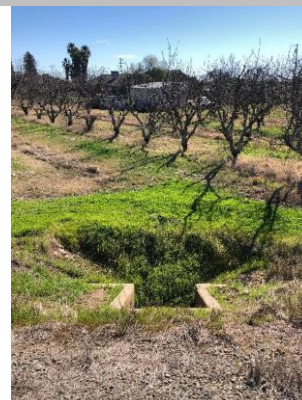
Photo 2 of 3 : UCIP_FA_2021_63798_92743.jpg

LS View: Headwall at LS toe.

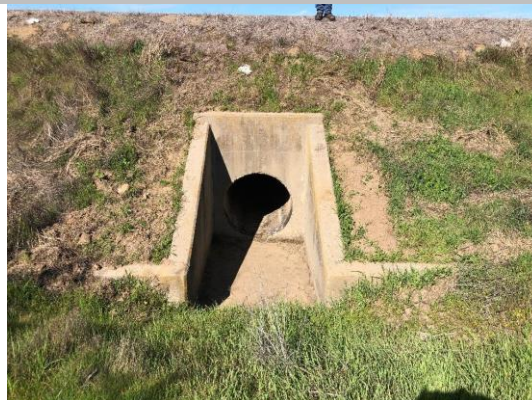
Photo 3 of 3 : UCIP_FA_2021_63798_92744.jpg

LS View: Headwall at LS toe.

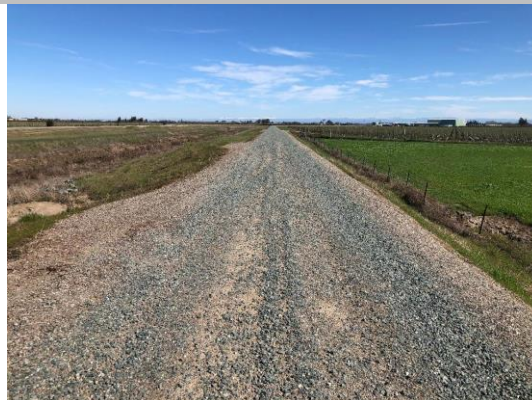
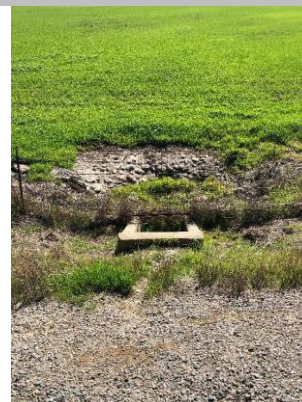
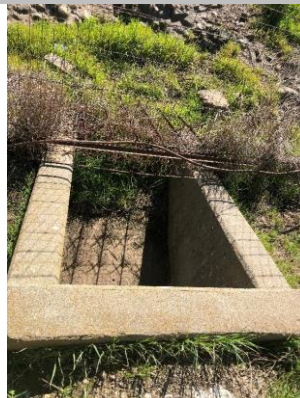
Photo 1 of 3 : UCIP_FA_2021_63800_92694.jpg

Comment Code					
Inspector Comment					
DS_ID:23752 FS_ID:63800 EP_NO: N/A Repair Type: Non-Urgent EVAL Issue: Unauthorized Encroachment, installed decades prior Crossing Status: Found UCIP Comments: 02/22/2021 Record was updated from No Action Needed to Non-Urgent. No permit was found authorizing this encroachment. CVFPB will need to review crossing to determine owner. DWR DMP has not found internal issues, LOF between 1 and 2. Recommend inspection in 5 years. The UCIP inspection was completed with DWR Inspector, S. Donovan, and LMA representative, J. Caruso. (N. Cholewinski - GEI) FIELD_STRUCT_DESC: 24-inch corrugated metal storm drainage pipe through the levee, 9.5 feet below the crown. Flap gate on the waterside (WS) end. Concrete U-shaped headwalls on both ends. Cobble grouted spillway across the berm. Cobble grouted apron on the landside (LS) toe. [Additional Reference(s): DWR Levee Log, 1990. USACE San Joaquin O&M Manual 612.2, 1967, (HLM 11.59) and 612 (addendum), February 1999, (HLM 11.60) (Station 612+48)]. FS Date: 2/22/2021

LS View: Headwall at LS toe.

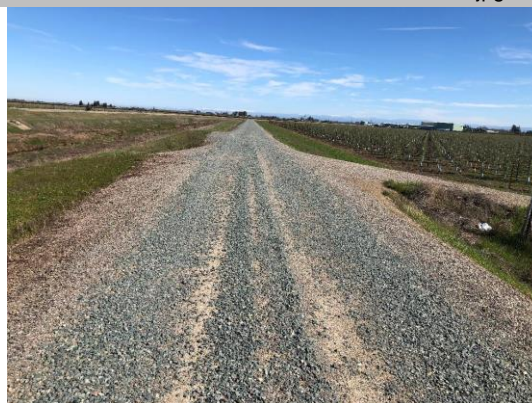
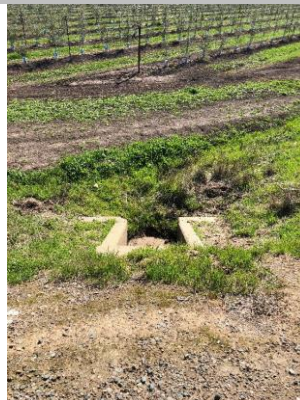
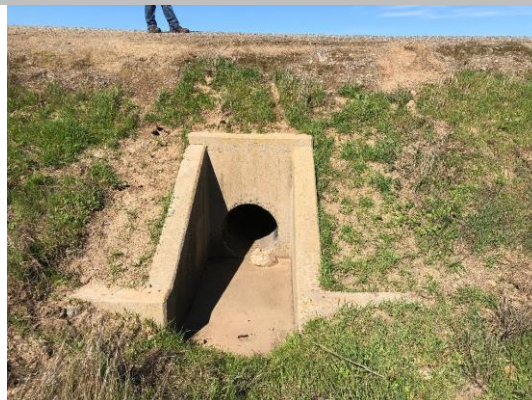
Photo 1 of 3 : UCIP_FA_2021_63801_92687.jpg

DS_ID:23753
 FS_ID:63801
 EP_NO: N/A
 Repair Type: Non-Urgent
 EVAL Issue: Unauthorized Encroachment, installed decades prior
 Crossing Status: Found
 UCIP Comments: 02/22/2021 Record was updated from No Action Needed to Non-Urgent. No permit was found authorizing this encroachment. CVFPB will need to review crossing to determine owner. DWR DMP has not found internal issues, LOF between 1 and 2. Recommend inspection in 5 years. The UCIP inspection was completed with DWR Inspector, S. Donovan, and LMA representative, J. Caruso. (N. Cholewinski - GEI)04/26/2017 Rodent activity is already accounted for via DWR FPIIB inspections. As per inspection chief G. Wylie, crossing has been downgraded from Non-Urgent to No Action Needed, as pipe integrity itself is not in question. (K. Fazel - UCIP)05/21/2014 Rodent activity at LS shoulder. (G. Wylie - FPIIB) FIELD_STRUCT_DESC: 24-inch corrugated metal storm drainage pipe through the levee, 7.5 feet below the crown. Flap gate on the waterside (WS) end. Concrete U-shaped headwalls on both slopes. Cobble grouted spillway on the WS slope. [Additional Reference(s): DWR Levee Log, 1990. USACE San Joaquin O&M Manual 612.2, 1967, (HLM 11.65) and 612 (addendum), February 1999, (HLM 11.99) (Station 633+20)].

LS View: Headwall at LS toe.

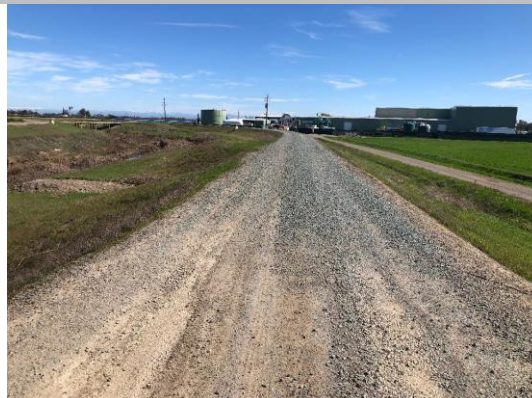
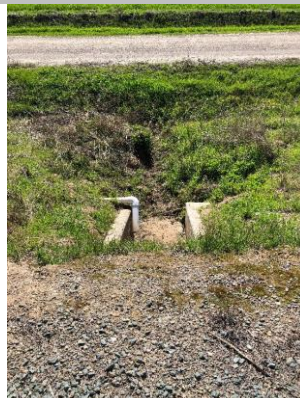
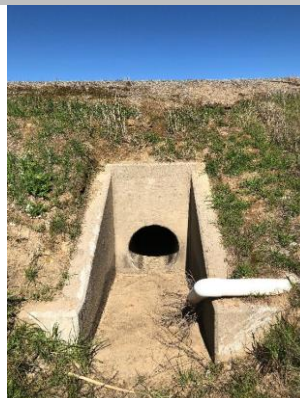
Photo 1 of 3 : UCIP_FA_2021_63840_92681.jpg

Comment Code						
Inspector Comment						
DS_ID:23754 FS_ID:63840 EP_NO: N/A Repair Type: Non-Urgent EVAL Issue: Unauthorized Encroachment, installed decades prior Crossing Status: Found UCIP Comments: 02/22/2021 Record was updated from No Action Needed to Non-Urgent. No permit was found authorizing this encroachment. CVFPB will need to review crossing to determine owner. DWR DMP has not found internal issues, LOF between 1 and 2. Recommend inspection in 5 years. A 4.5-inch PVC pipe is positioned to discharge at the LS inlet. The 4.5-inch PVC pipe is an unauthorized engroachment that has been installed along the LS toe. Recommend having the CVFPB review this record to have landowner remove the illegal encroachment along the LS toe. The UCIP inspection was completed with DWR Inspector, S. Donovan, and LMA representative, J. Caruso. (N. Cholewinski - GEI)04/26/2017 Rodent activity is already accounted for via DWR FPIIB inspections. As per inspection chief G. Wylie, crossing has been downgraded from Non-Urgent to No Action Needed, as pipe integrity itself is not in question. (K. Fazel - UCIP)05/21/2014 Rodent activity at LS shoulder. (G. Wylie - FPIIB) FIELD_STRUCT_DESC: 24-inch corrugated metal drainage pipe through the levee, 7.5 feet below the crown. Flap gate on the waterside (WS) end. Concrete U-shaped headwalls on both ends. Cobble grouted spillway across the berm. Cobble grouted apron on the landside (LS) end. [Additional Reference(s): DWR Levee Log, 1990. USACE San Joaquin O&M Manual 612.2, 1967, (HLM 12.06)]. FS Date: 2/22/2021

LS View: Headwall at LS toe.

LS View: Headwall at LS toe. PVC pipe discharging at inlet.

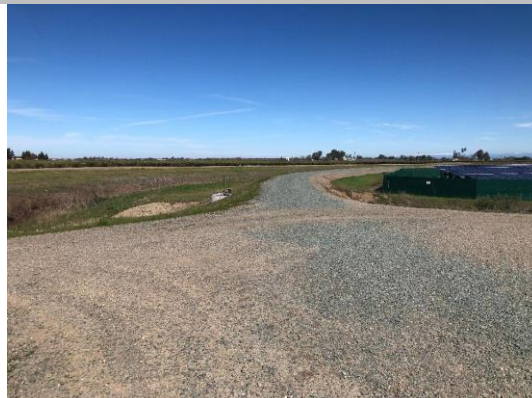
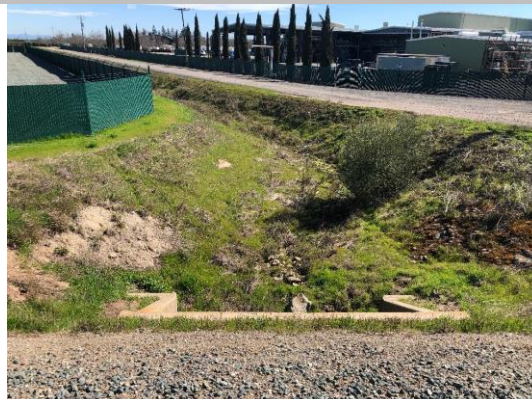
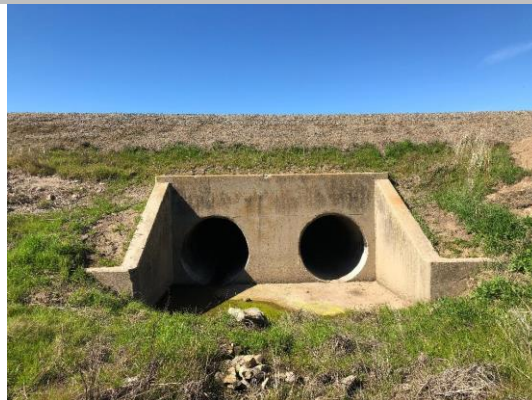
Photo 1 of 3 : UCIP_FA_2021_63804_92661.jpg

Comment Code						
Inspector Comment						
DS_ID:23756 FS_ID:63804 EP_NO: N/A Repair Type: Non-Urgent EVAL Issue: Safety Issue Crossing Status: Found UCIP Comments: 02/22/2021 Pipe status is still Non-Urgent. No permit was found authorizing this encroachment. CVFPB will need to review crossing to determine owner. DWR DMP has not found internal issues, LOF between 1 and 2. Recommend inspection in 5 years. Riser lid damage. Recommend adding lid to riser as a safety measure. The UCIP inspection was completed with DWR Inspector, S. Donovan, and LMA representative, J. Caruso. (N. Cholewinski - GEI)05/21/2014 CMP riser missing cover on WS slope. (W. Wylie - DWR UCIP) FIELD_STRUCT_DESC: 1 of 2: 48-inch corrugated metal storm drainage pipe through the levee, 8.5 feet below the crown. Slide gate in 60-inch corrugated metal riser unit on the waterside (WS) slope. Concrete U-shaped headwalls on both ends. Cobble grouted spillway on the WS end. Cobble grouted apron on the landside (LS) end. [Additional Reference(s): DWR Levee Log, 1990. USACE San Joaquin O&M Manual 612.2, 1967, (HLM 12.20) and 612 (addendum), February 1999, (HLM 12.13) (Station 640+50)]. FS Date: 2/22/2021

LS View: Headwall at LS toe.
