**Flood Control Project Maintenance
Levee Inspections**

Maintenance Issue Types Only, Levee Inspection Report By Mile - Fall 2021

San Joaquin County Flood Control and Water Conservation District

Waterway	Bank	Unit Miles	Inspection Start/End	Inspector
Unit No. 01 Littlejohn Creek	Left	2.59	10/21/2021 10/21/2021	Alberto De Leon

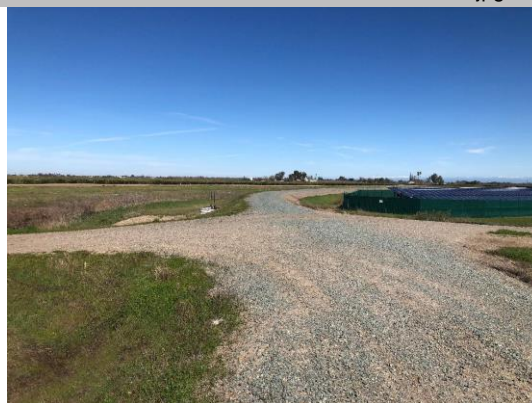
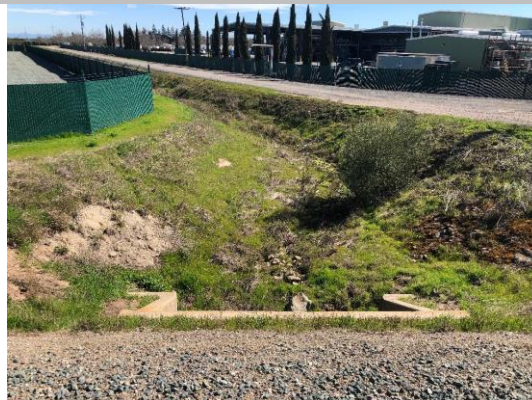
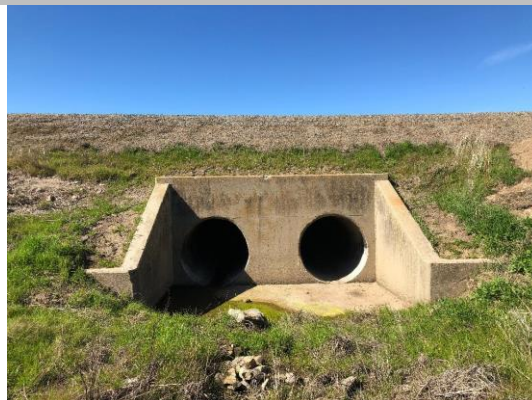
Photo 1 of 3 : UCIP_FA_2021_63805_92650.jpg

DS_ID:23818
 FS_ID:63805
 EP_NO: N/A
 Repair Type: Non-Urgent
 EVAL Issue: Safety Issue
 Crossing Status: Found
 UCIP Comments: 02/22/2021 Pipe status is still Non-Urgent. No permit was found authorizing this encroachment. CVFPB will need to review crossing to determine owner. DWR DMP has not found internal issues, LOF between 1 and 2. Recommend inspection in 5 years. Riser lid missing. Recommend adding riser lid for safety reasons. The UCIP inspection was completed with DWR Inspector, S. Donovan, and LMA representative, J. Caruso. (N. Cholewinski - GEI)05/21/2014 CMP riser missing cover on WS slope may be hazard. (W. Wylie - DWR UCIP)
 FIELD_STRUCT_DESC: 2 of 2: 48-inch corrugated metal storm drainage pipe through the levee, 8.5 feet below the crown. Slide gate in 60-inch corrugated metal riser unit on the waterside (WS) slope. Concrete U-shaped headwalls on both ends. Cobble grouted spillway on the WS end. Cobble grouted apron on the landside (LS) end.

LS View: Headwall at LS toe.

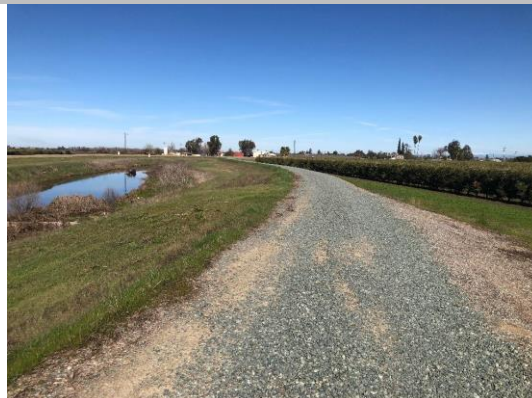
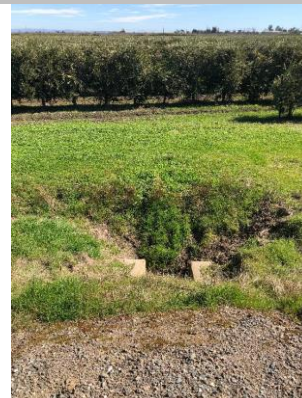
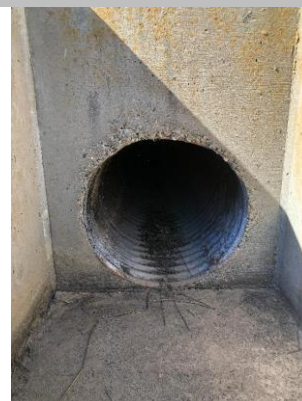
Photo 1 of 3 : UCIP_FA_2021_63806_92644.jpg

Comment Code						
Inspector Comment						
DS_ID:23757 FS_ID:63806 EP_NO: N/A Repair Type: Non-Urgent EVAL Issue: Unauthorized Encroachment, installed decades prior Crossing Status: Found UCIP Comments: 02/22/2021 Pipe status is still Non-Urgent. No permit was found authorizing this encroachment. CVFPB will need to review crossing to determine owner. DWR DMP has not found internal issues, LOF between 1 and 2. Recommend inspection in 5 years. The UCIP inspection was completed with DWR Inspector, S. Donovan, and LMA representative, J. Caruso. (N. Cholewinski – GEI)05/21/2014 Some sediment buildup in pipe at inlet. (W. Wylie - DWR DMP) FIELD_STRUCT_DESC: 24-inch corrugated metal storm drainage pipe through the levee, 9 feet below the crown. Flap gate on the waterside (WS) end. Concrete U-shaped headwalls on both ends. Cobble grouted spillway across the berm. Cobble grouted apron on the landside (LS) end. [Additional Reference(s): DWR Levee Log, 1990. USACE San Joaquin O&M Manual 612.2, 1967, (HLM 12.43) and 612 (addendum), February 1999, (HLM 12.36) (Station 652+74)]. FS Date: 2/22/2021

LS View: Headwall at LS toe.

LS View: Pipe at LS toe.

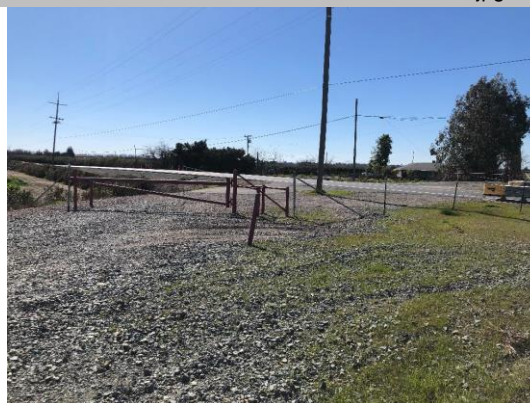
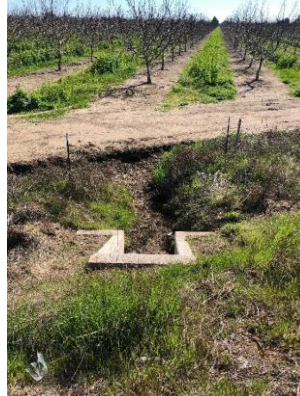
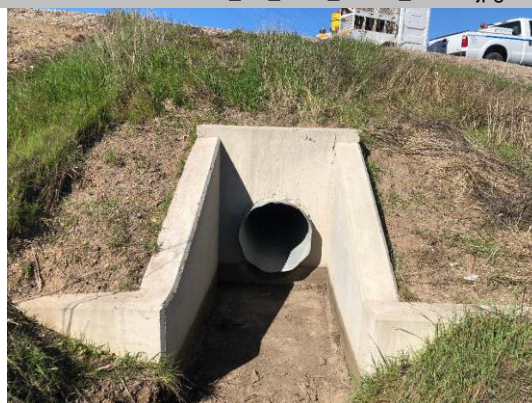
Photo 1 of 3 : UCIP_FA_2021_63846_92627.jpg

DS_ID:23761
 FS_ID:63846
 EP_NO: N/A
 Repair Type: Urgent
 EVAL Issue: Pipe Integrity
 Crossing Status: Found
 UCIP Comments: 02/22/2021 Record was updated from No Action Needed to Urgent. DWR DMP has found integrity issues, LOF between 5 and 6. Crossing will be monitored until funding becomes available for removal. No permit was found authorizing this encroachment. There appears to be a gap between the headwall and concrete apron. Recommend monitoring the gap to determine if it is associated with undermining occurring. CVFPB will need to review crossing to determine owner. The UCIP inspection was completed with LMA representative, J. Caruso. (N. Cholewinski - GEI)
 FIELD_STRUCT_DESC: 24-inch corrugated metal storm drainage pipe through the levee, 7.5 feet below the crown. Flap gate on the waterside (WS) end. Concrete U-shaped headwalls on both ends. Cobble grouted spillway across berm. Cobble grouted apron on the landside (LS) end. [Additional Reference(s): DWR Levee Log, 1990. USACE San Joaquin O&M Manual 612.2, 1967, (HLM 12.78) and 612 (addendum), February 1999, (HLM 12.70) (Station 670+43)].

LS View: Headwall at LS toe.

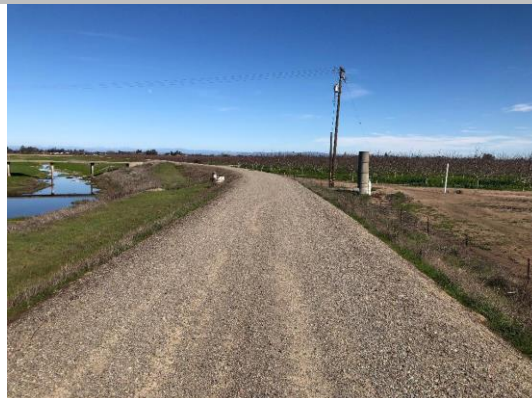
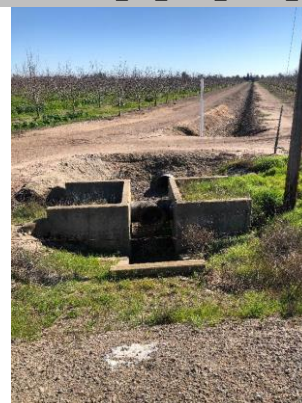
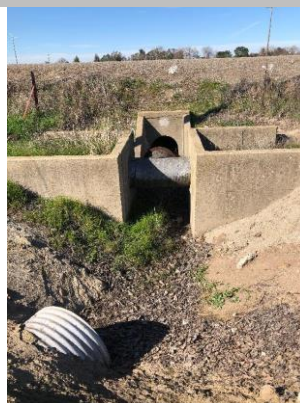
Photo 1 of 3 : UCIP_FA_2021_63809_92606.jpg

Comment Code						
Inspector Comment						
DS_ID:23764 FS_ID:63809 EP_NO: N/A Repair Type: Non-Urgent EVAL Issue: Unauthorized Encroachment, installed decades prior Crossing Status: Found UCIP Comments: 02/22/2021 Record was updated from No Action Needed to Non-Urgent. No permit was found authorizing this encroachment. CVFPB will need to review crossing to determine owner. DWR DMP has not found internal issues, LOF between 1 and 2. Recommend inspection in 5 years. The UCIP inspection was completed with LMA representative, J. Caruso. (N. Cholewinski – GEI) FIELD_STRUCT_DESC: 36-inch corrugated metal storm drainage pipe through the levee, 9 feet below the crown. Flap gate on the waterside (WS) end. Concrete U-shaped headwalls on both ends. Cobble grouted spillway on the WS end. Cobble grouted apron on the landside (LS) end. [Additional Reference(s): DWR Levee Log, 1990. USACE San Joaquin O&M Manual 612.2, 1967, (HLM 12.94) and 612 (addendum), February 1999, (HLM 12.86) (Station 678+88)]. FS Date: 2/22/2021

LS View: Headwall and flapgate at LS toe. Abandoned irrigation structure at LS toe.

LS View: Abandoned irrigation structure at LS toe.

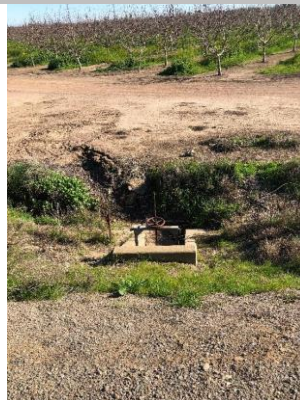
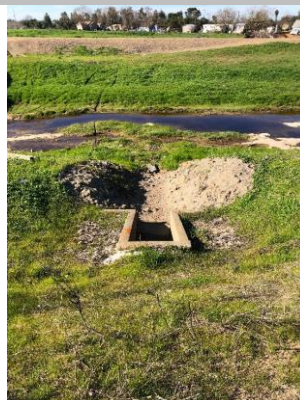
Photo 1 of 3 : UCIP_FA_2021_64149_92597.jpg

DS_ID:23765
 FS_ID:64149
 EP_NO: N/A
 Repair Type: Non-Urgent
 EVAL Issue: Pipe Damage
 Crossing Status: Found
 UCIP Comments: 02/22/2021 Record was updated from No Action Needed to Non-Urgent. DWR DMP has found integrity issues, LOF between 4 and 5. Crossing will be monitored until funding becomes available for rehabilitation. No permit was found authorizing this encroachment. CVFPB will need to review crossing to determine owner. The UCIP inspection was completed with LMA representative, J. Caruso. (N. Cholewinski - GEI)
 FIELD_STRUCT_DESC: 24-inch corrugated metal drainage pipe through the levee, 9 feet below the crown. Flap gate on the waterside (WS) end. Slide gate on the landside (LS) end. Concrete U-shaped headwalls on both ends. Cobble grouted spillway across the berm. Cobble grouted apron on the LS end. [Additional Reference(s): DWR Levee Log, 1990. USACE San Joaquin O&M Manual 612.2, 1967, (HLM 13.00)].

LS View: Headwall and slide gate at LS toe.

WS View: Headwall and flapgate at WS toe.

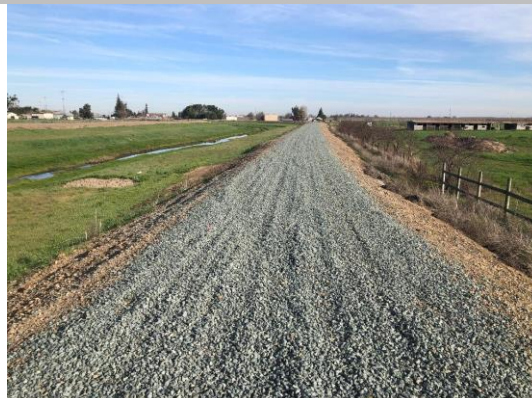
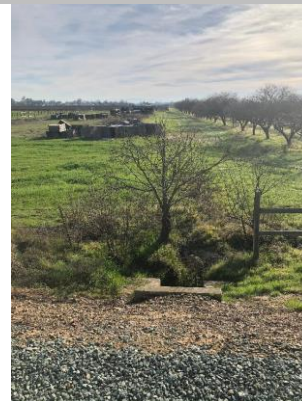
Photo 1 of 3 : UCIP_FA_2021_63811_92581.jpg

Comment Code						
Inspector Comment						
DS_ID:23767 FS_ID:63811 EP_NO: N/A Repair Type: Non-Urgent EVAL Issue: Unauthorized Encroachment, installed decades prior Crossing Status: Found UCIP Comments: 02/23/2021 Record was updated from No Action Needed to Non-Urgent. No permit was found authorizing this encroachment. CVFPB will need to review crossing to determine owner. DWR DMP has not found internal issues, LOF between 1 and 2. Recommend inspection in 5 years. The UCIP inspection was completed with LMA representative, J. Caruso. (N. Cholewinski – GEI) FIELD_STRUCT_DESC: 24-inch corrugated metal drainage pipe through the levee, 7 feet below the crown. Concrete U-shaped headwall on both ends. Flap gate on the waterside (WS) end. Cobble grouted spillway. Cobble grouted intake on the landside (LS). [Additional Reference(s): DWR Levee Log, 1990. USACE San Joaquin O&M Manual 612.2, 1967, (HLM 13.26)]. FS Date: 2/23/2021

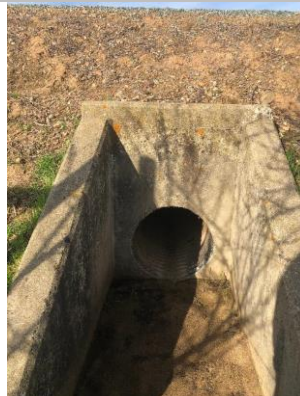
Photo 3 of 3 : UCIP_FA_2021_63811_92583.jpg

LS View: Headwall at LS toe.

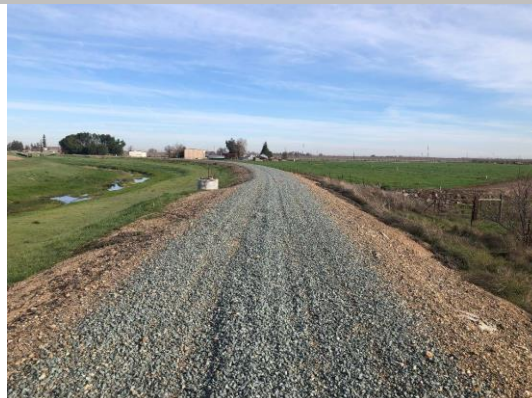
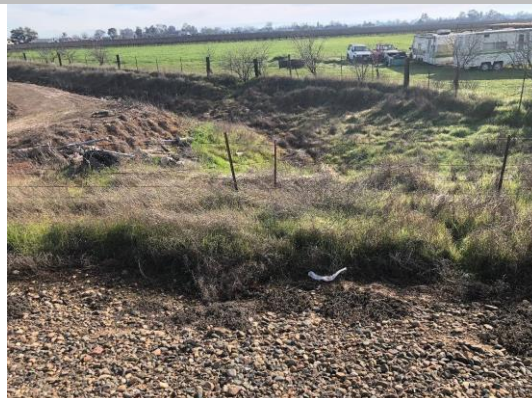
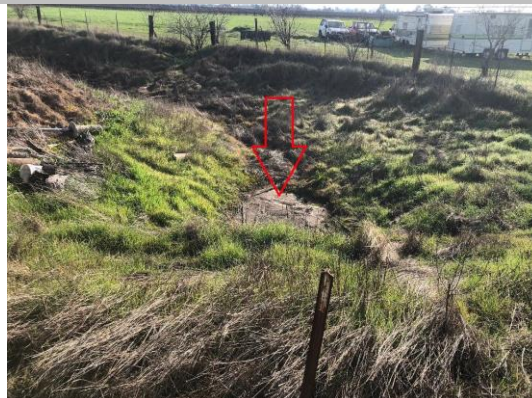
Comment Code						
Inspector Comment						
DS_ID:23768 FS_ID:63812 EP_NO: N/A Repair Type: Non-Urgent EVAL Issue: Safety Issue Crossing Status: Found UCIP Comments: 02/23/2021 Pipe status is still Non-Urgent. No permit was found authorizing this encroachment. CVFPB will need to review crossing to determine owner. DWR DMP has not found internal issues, LOF between 1 and 2. Recommend inspection in 5 years. LS not accessible due to barbed cattle fencing. Riser lid missing. Recommend adding lid to riser as a safety measure. The UCIP inspection was completed with LMA representative, J. Caruso. (N. Cholewinski – GEI)05/21/2014 Some debris buildup at inlet. No lid on CMP riser on WS slope. (W. Wylie - DWR DMP) FIELD_STRUCT_DESC: 1 of 2: 36-inch corrugated metal drainage pipe through the levee, 10 feet below the crown. Concrete U-shaped headwall on both ends. Slide gate in corrugated metal riser unit on the waterside (WS) slope. Flap gate on the WS end. [Additional Reference(s): DWR Levee Log, 1990. USACE San Joaquin O&M Manual 612.2, 1967, (HLM 13.35)]. FS Date: 2/23/2021

LS View: Pipe at LS toe with cattle fencing around opening.

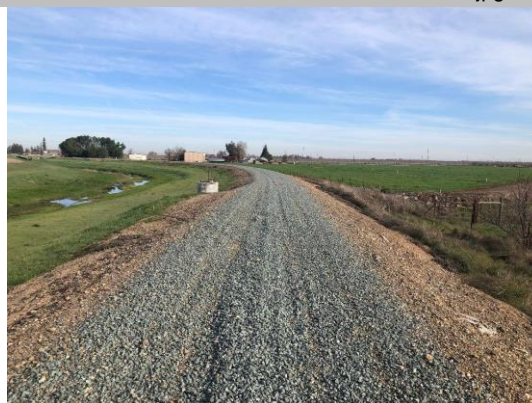
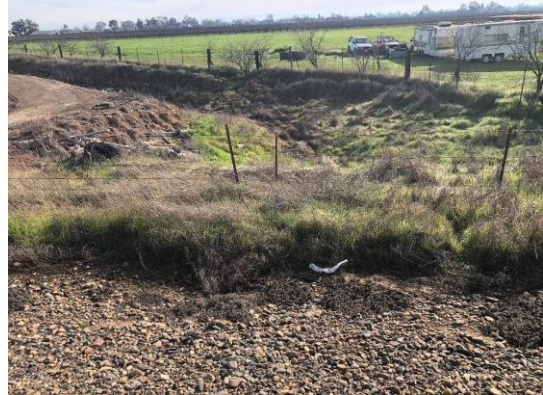
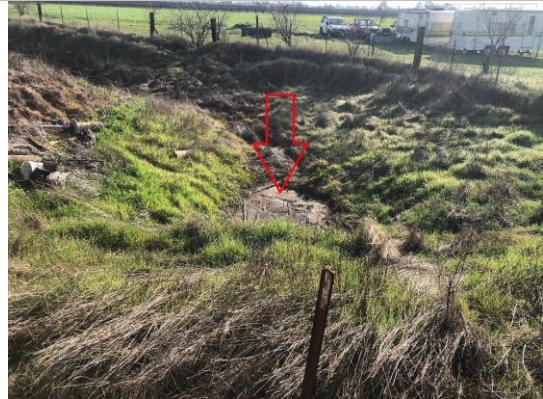
Comment Code					
Inspector Comment					
DS_ID:23816 FS_ID:63813 EP_NO: N/A Repair Type: Non-Urgent EVAL Issue: Safety Issue Crossing Status: Found UCIP Comments: 02/23/2021 Pipe status is still Non-Urgent. No permit was found authorizing this encroachment. CVFPB will need to review crossing to determine owner. DWR DMP has not found internal issues, LOF between 1 and 2. Recommend inspection in 5 years. LS not accessible due to barbed cattle fencing. Riser lid missing. Recommend adding lid to riser as a safety measure. The UCIP inspection was completed with LMA representative, J. Caruso. (N. Cholewinski – GEI)05/21/2014 Some debris buildup at inlet and no lid on standpipe at WS shoulder. (W. Wylie - DWR DMP) FIELD_STRUCT_DESC: 2 of 2: 36-inch corrugated metal drainage pipe through the levee, 10 feet below the crown. Concrete U-shaped headwall on both ends. Slide gate in corrugated metal riser unit on the waterside (WS) slope. Flap gate on the WS end. [Additional Reference(s): DWR Levee Log, 1990. USACE San Joaquin O&M Manual 612.2, 1967, (HLM 13.35)]. FS Date: 2/23/2021

LS View: Cattle fencing around inlet at LS toe.

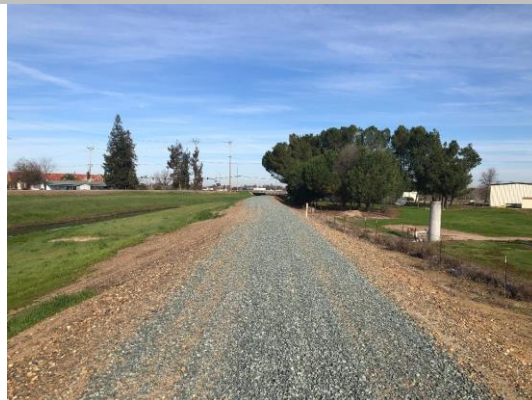
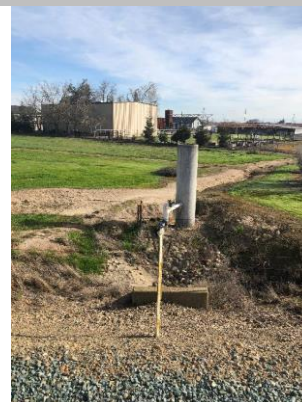
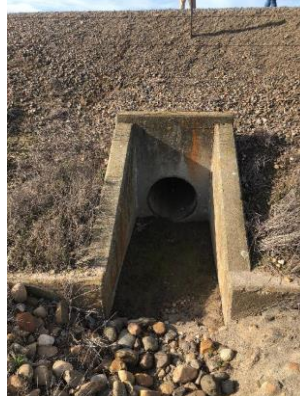
Comment Code					
Inspector Comment					
DS_ID:23769 FS_ID:63814 EP_NO: N/A Repair Type: Non-Urgent EVAL Issue: Unauthorized Encroachment, installed decades prior Crossing Status: Found UCIP Comments: 02/23/2021 Record was updated from No Action Needed to Non-Urgent. No permit was found authorizing this encroachment. CVFPB will need to review crossing to determine owner. DWR DMP has not found internal issues, LOF between 1 and 2. Recommend inspection in 5 years. Standpipe, 24-inch OD, located landward of LS toe is discharging at storm drain inlet at LS toe. The UCIP inspection was completed with LMA representative, J. Caruso. (N. Cholewinski – GEI) FIELD_STRUCT_DESC: 24-inch corrugated metal drainage pipe through the levee, 8 feet below the crown. Concrete U-shaped headwall on both ends. Flap gate on the waterside (WS) end. Cobble grouted spillway. Cobble grouted intake on the landside (LS). [Additional Reference(s): DWR Levee Log, 1990. USACE San Joaquin O&M Manual 612.2, 1967, (HLM 13.50)]. FS Date: 2/23/2021

LS View: Headwall at LS toe.

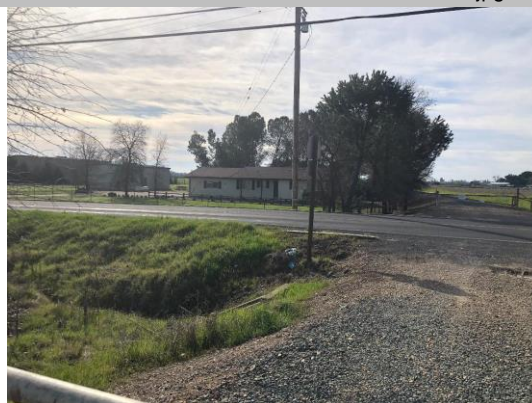
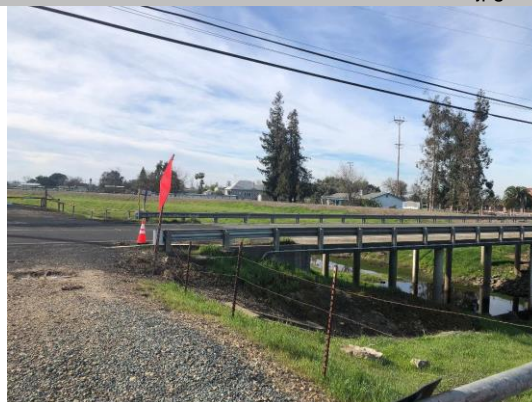
Comment Code					
Inspector Comment					
DS_ID:23770 FS_ID:63221 EP_NO: N/A Repair Type: Non-Urgent EVAL Issue: Pipe Damage Crossing Status: Found UCIP Comments: 02/23/2021 Record was updated from No Action Needed to Non-Urgent. DWR DMP has found integrity issues, LOF between 4 and 5. Crossing will be monitored until funding becomes available for rehabilitation. No permit was found authorizing this encroachment. CVFPB will need to review crossing to determine owner. Slight weathering of interior pipe coating observed. The UCIP inspection was completed with LMA representative, J. Caruso. (N. Cholewinski - GEI) FIELD_STRUCT_DESC: 24-inch corrugated metal drainage pipe through the levee, 6 feet below the crown. Concrete U-shaped headwall on both ends. Flap gate on the waterside (WS) end. Cobble grouted spillway. Cobble grouted intake on the landside (LS). [Additional Reference(s): DWR Levee Log, 1990. USACE San Joaquin O&M Manual 612.2, 1967, (HLM 13.60)]. FS Date: 2/23/2021

Crown Overview and LS View

Crown Overview and WS View

WS View

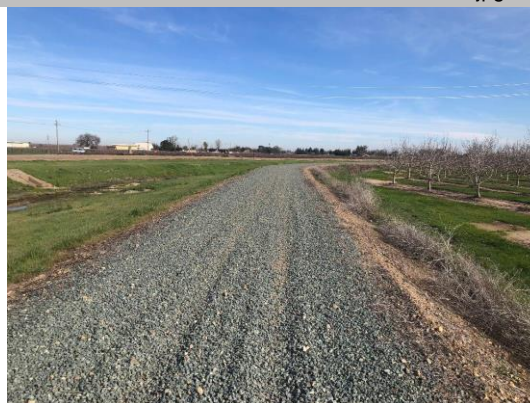
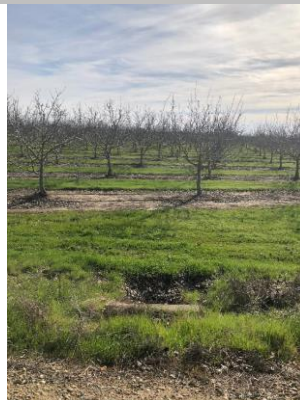
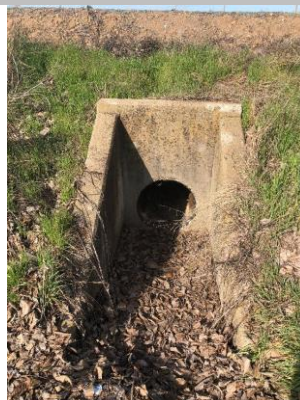
DS_ID:23771
 FS_ID:63816
 EP_NO: N/A
 Repair Type: Non-Urgent
 EVAL Issue: Unauthorized Encroachment, installed decades prior
 Crossing Status: Found
 UCIP Comments: 02/23/2021 Record was updated from No Action Needed to Non-Urgent. No permit was found authorizing this encroachment. CVFPB will need to review crossing to determine owner. DWR DMP has not found internal issues, LOF between 1 and 2. Recommend inspection in 5 years. Leaf vegetation build-up present at LS toe. The UCIP inspection was completed with LMA representative, J. Caruso. (N. Cholewinski – GEI)
 FIELD_STRUCT_DESC: 24-inch corrugated metal drainage pipe through the levee, 6 feet below the crown. Concrete U-shaped headwall on both ends. Flap gate on the waterside (WS) end. Cobble grouted spillway. Cobble grouted intake on the landside (LS). [Additional Reference(s): DWR Levee Log, 1990. USACE San Joaquin O&M Manual 612.2, 1967, (HLM 13.81)].

LS View: Headwall at LS toe.

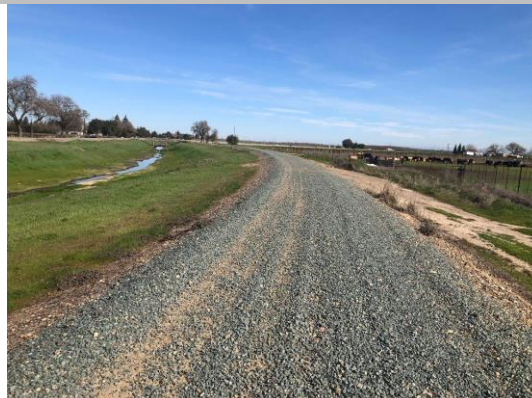
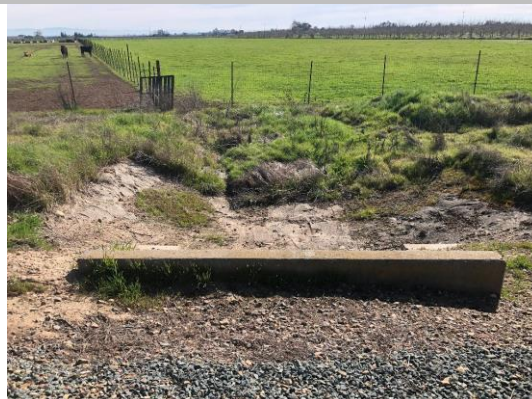
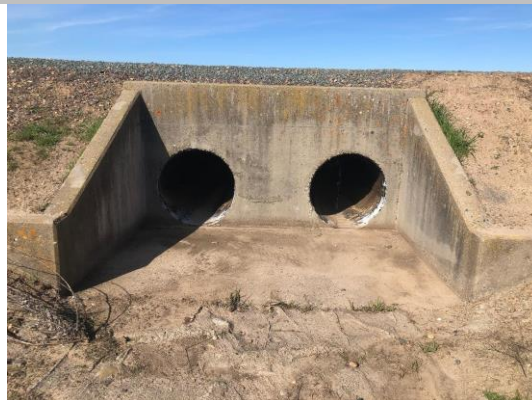
Comment Code						
Inspector Comment						
DS_ID:23773 FS_ID:63216 EP_NO: N/A Repair Type: Urgent EVAL Issue: Pipe Integrity Crossing Status: Found UCIP Comments: 02/23/2021 Record was updated from No Action Needed to Urgent. DWR DMP has found integrity issues, LOF between 5 and 6. Crossing will be monitored until funding becomes available for removal. No permit was found authorizing this encroachment. CVFPB will need to review crossing to determine owner. Slight offset, <1-inch, observed within interior of pipe at approximately 10 feet inside pipe from LS pipe opening. Small gap, approximately 1/4-inch, present at base of pipe along exterior of pipe opening at LS toe. The UCIP inspection was completed with LMA representative, J. Caruso. (N. Cholewinski - GEI) FIELD_STRUCT_DESC: 1 of 2: 36-inch corrugated metal drainage pipe through the levee, 4 feet below the crown. Concrete U-shaped headwall on both ends. Flap gate on the waterside (WS) end. Cobble grouted spillway. Cobble grouted intake on the landside (LS). [Additional Reference(s): DWR Levee Log, 1990. USACE San Joaquin O&M Manual 612.2, 1967, (HLM 14.16)]. FS Date: 2/23/2021

LS View: Headwall at LS toe.

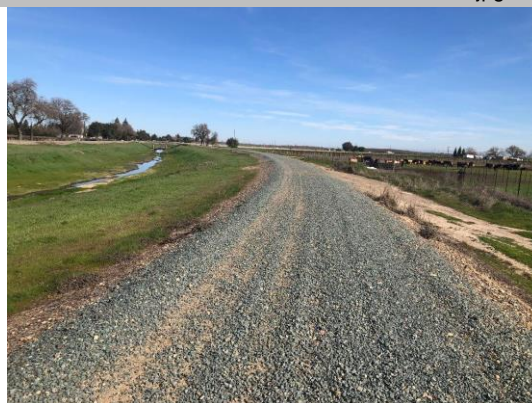
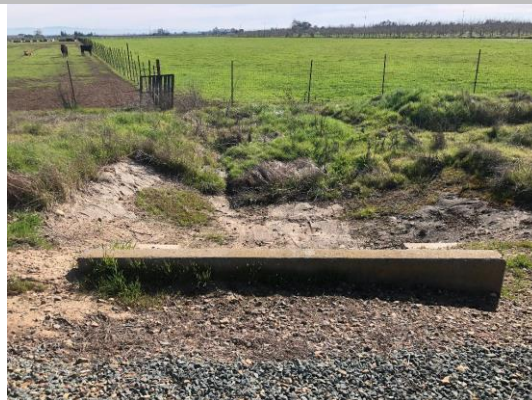
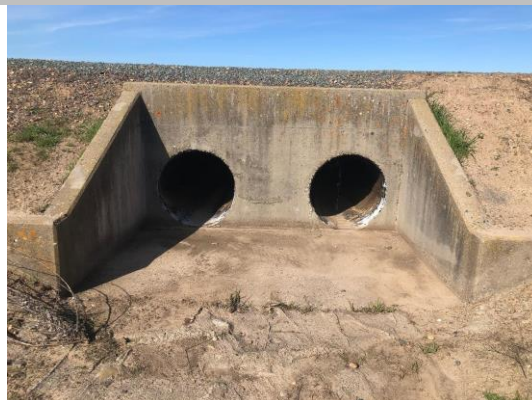
DS_ID:23815
 FS_ID:63214
 EP_NO: N/A
 Repair Type: Non-Urgent
 EVAL Issue: Unauthorized Encroachment, installed decades prior
 Crossing Status: Found
 UCIP Comments: 02/23/2021 Record was updated from No Action Needed to Non-Urgent. No permit was found authorizing this encroachment. CVFPB will need to review crossing to determine owner. DWR DMP has not found internal issues, LOF between 1 and 2. Recommend inspection in 5 years. The UCIP inspection was completed with LMA representative, J. Caruso. (N. Cholewinski – GEI)
 FIELD_STRUCT_DESC: 2 of 2: 36-inch corrugated metal drainage pipe through the levee, 4 feet below the crown. Concrete U-shaped headwall on both ends. Flap gate on the waterside (WS) end. Cobble grouted spillway. Cobble grouted intake on the landside (LS). [Additional Reference(s): DWR Levee Log, 1990. USACE San Joaquin O&M Manual 612.2, 1967, (HLM 14.16)].
 FS Date: 2/23/2021

LS View: Headwall at LS toe.

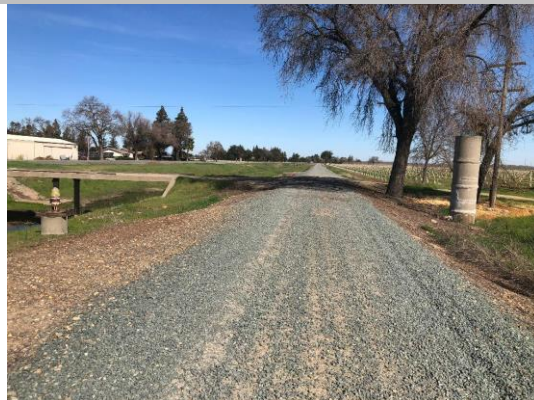
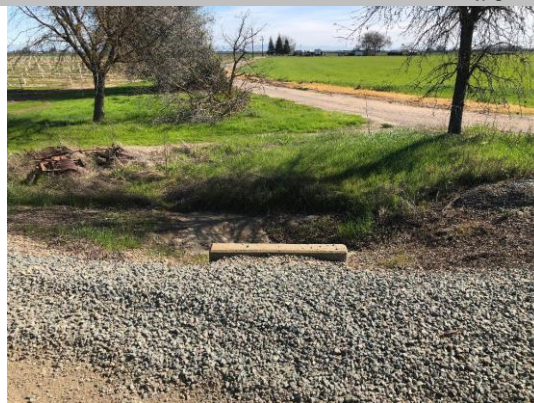
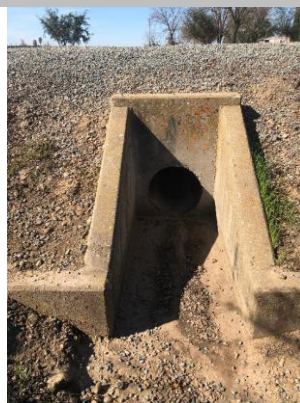
Comment Code						
Inspector Comment						
DS_ID:23775 FS_ID:63819 EP_NO: N/A Repair Type: Non-Urgent EVAL Issue: Unauthorized Encroachment, installed decades prior Crossing Status: Found UCIP Comments: 02/23/2021 Record was updated from No Action Needed to Non-Urgent. No permit was found authorizing this encroachment. CVFPB will need to review crossing to determine owner. DWR DMP has not found internal issues, LOF between 1 and 2. Recommend inspection in 5 years. The UCIP inspection was completed with LMA representative, J. Caruso. (N. Cholewinski – GEI) FIELD_STRUCT_DESC: 24-inch corrugated metal drainage pipe through the levee, 4 feet below the crown. Concrete U-shaped headwall on both ends. Flap gate on the waterside (WS) end. Cobble grouted spillway. Cobble grouted intake on the landside (LS). [Additional Reference(s): DWR Levee Log, 1990. USACE San Joaquin O&M Manual 612.2, 1967, (HLM 14.35)]. FS Date: 2/23/2021

Crown Overview - Storm drain located on upstream side of bridge.

LS View: Headwall at LS toe.

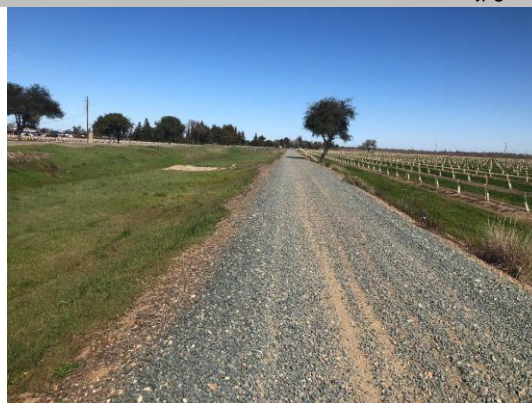
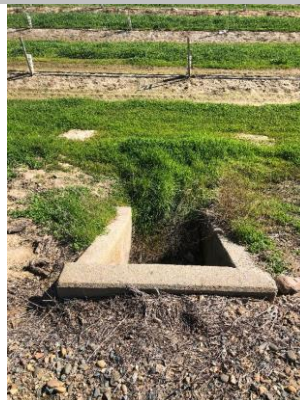
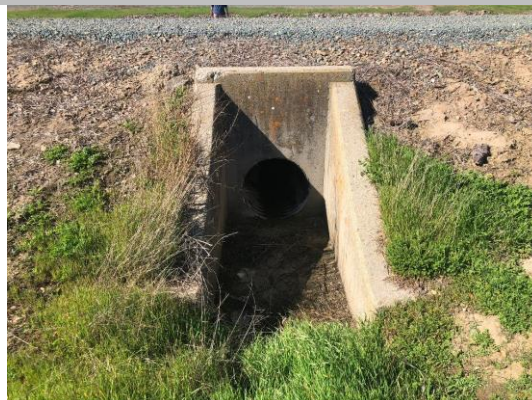
DS_ID:23776
 FS_ID:63820
 EP_NO: N/A
 Repair Type: Non-Urgent
 EVAL Issue: Unauthorized Encroachment, installed decades prior
 Crossing Status: Found
 UCIP Comments: 02/23/2021 Pipe status is still Non-Urgent. No permit was found authorizing this encroachment. CVFPB will need to review crossing to determine owner. DWR DMP has not found internal issues, LOF between 1 and 2. Recommend inspection in 5 years. Observed small gap, approximately 1/4-inch wide, at base of pipe on LS toe. The UCIP inspection was completed with LMA representative, J. Caruso. (N. Cholewinski – GEI)05/21/2014 Some silt buildup inside pipe. (W. Wylie - DWR DMP)
 FIELD_STRUCT_DESC: 24-inch corrugated metal drainage pipe through the levee, 4 feet below the crown. Concrete U-shaped headwall on both ends. Flap gate on the waterside (WS) end. Cobble grouted spillway. Cobble grouted intake on the landside (LS). [Additional Reference(s): DWR Levee Log, 1990. USACE San Joaquin O&M Manual 612.2, 1967, (HLM 14.46)].

LS View: Headwall at LS toe.

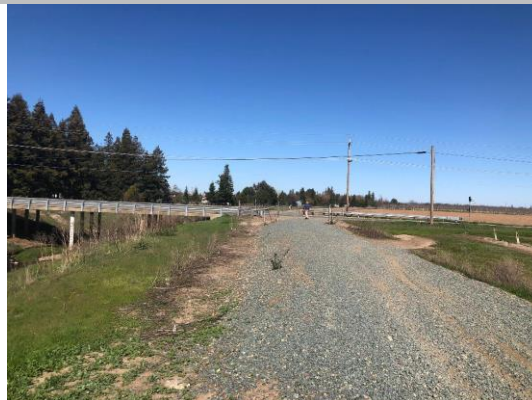
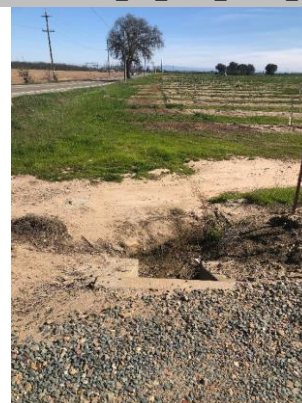
Comment Code					
Inspector Comment					
DS_ID:23778 FS_ID:63821 EP_NO: N/A Repair Type: Non-Urgent EVAL Issue: Unauthorized Encroachment, installed decades prior Crossing Status: Found UCIP Comments: 02/23/2021 Pipe status is still Non-Urgent. No permit was found authorizing this encroachment. CVFPB will need to review crossing to determine owner. DWR DMP has not found internal issues, LOF between 1 and 2. Recommend inspection in 5 years. The UCIP inspection was completed with LMA representative, J. Caruso. (N. Cholewinski – GEI)05/21/2014 Some silt buildup inside pipe. (W. Wylie - DWR DMP) FIELD_STRUCT_DESC: 24-inch corrugated metal drainage pipe through the levee, 4 feet below the crown. Concrete U-shaped headwall on both ends. Flap gate on the waterside (WS) end. Cobble grouted spillway. Cobble grouted intake on the landside (LS). [Additional Reference(s): DWR Levee Log, 1990. USACE San Joaquin O&M Manual 612.2, 1967, (HLM 14.69)]. FS Date: 2/23/2021

LS View: Headwall on LS toe.

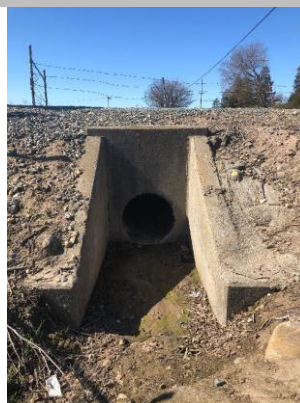
Photo 3 of 3 : UCIP_FA_2021_63821_92472.jpg

LS View: Headwall at LS toe.

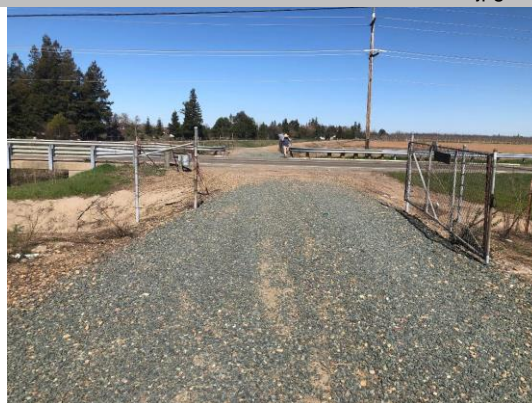
Photo 1 of 3 : UCIP_FA_2021_63823_92457.jpg

DS_ID:23779
 FS_ID:63823
 EP_NO: N/A
 Repair Type: Non-Urgent
 EVAL Issue: Unauthorized Encroachment, installed decades prior
 Crossing Status: Found
 UCIP Comments: 02/23/2021 Record was updated from No Action Needed to Non-Urgent . No permit was found authorizing this encroachment. CVFPB will need to review crossing to determine owner. DWR DMP has not found internal issues, LOF between 1 and 2. Recommend inspection in 5 years. The UCIP inspection was completed with LMA representative, J. Caruso. (N. Cholewinski - GEI)
 FIELD_STRUCT_DESC: 24-inch corrugated metal drainage pipe through the levee, 6.5 feet below the crown. Concrete U-shaped headwall on both ends. Flap gate on the waterside (WS) end. Cobble grouted spillway. Cobble grouted intake on the landside (LS).
 [Additional Reference(s): DWR Levee Log, 1990. USACE San Joaquin O&M Manual 612.2, 1967, (HLM 14.70)].
 FS Date: 2/23/2021

Crown Overview - Utility across road.

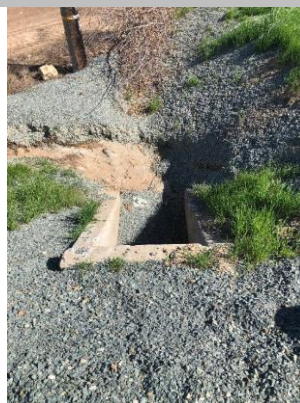
Photo 2 of 3 : UCIP_FA_2021_63823_92458.jpg

LS View: Headwall at LS toe.

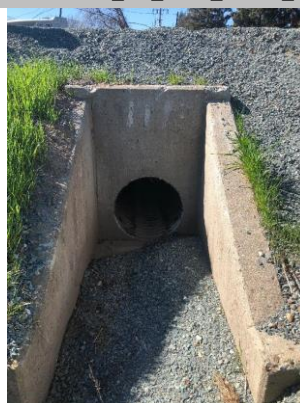
Photo 3 of 3 : UCIP_FA_2021_63823_92459.jpg

LS View: Headwall at LS toe.

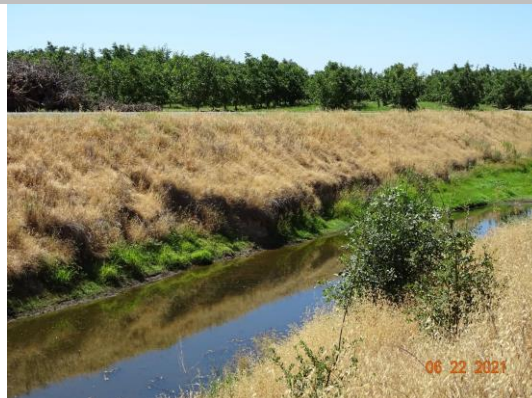
Photo 1 of 2 : SJR2021_NA0017U08RM21.46_6.JPG

06/22/2021: A large rodent hole was discovered at the bank toe a few feet upstream of the erosion. Otherwise, no significant changes were observed during the annual survey.

07/31/2020: Observed two scour locations at the toe, beneath the existing erosion, approximately 5 ft long and 3 to 4 high. Also noticed some signs of burrow activity.

08/01/2019: Erosion likely has been caused by rainfall runoff.

6/22/2021: View of the erosion from the opposite bank.

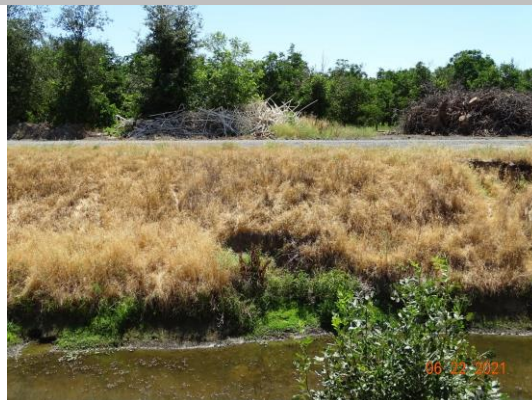
Photo 2 of 2 : SJR2021_NA0017U08RM21.46_4.JPG

6/22/2021: Close-up view of the erosion.

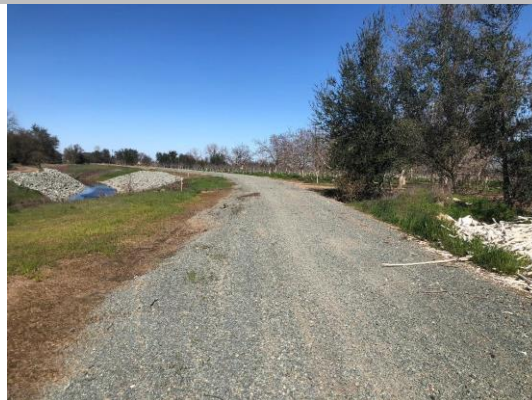
Photo 1 of 3 : UCIP_FA_2021_63205_92449.jpg

Comment Code						
Inspector Comment						
DS_ID:23780 FS_ID:63205 EP_NO: N/A Repair Type: Non-Urgent EVAL Issue: Pipe Damage Crossing Status: Found UCIP Comments: 02/23/2021 Record was updated from No Action Needed to Non-Urgent. DWR DMP has found integrity issues, LOF between 4 and 5. Crossing will be monitored until funding becomes available for rehabilitation. No permit was found authorizing this encroachment. CVFPB will need to review crossing to determine owner. The UCIP inspection was completed with LMA representative, J. Caruso. (N. Cholewinski - GEI) FIELD_STRUCT_DESC: 12-inch corrugated metal drainage pipe through the levee, 3 feet below the crown. Flap gate on the waterside (WS) end. Cobble grouted spillway. Cobble grouted intake on the landside (LS). [Additional Reference(s): DWR Levee Log, 1990. USACE San Joaquin O&M Manual 612.2, 1967, (HLM 15.08)]. FS Date: 2/23/2021

Crown Overview

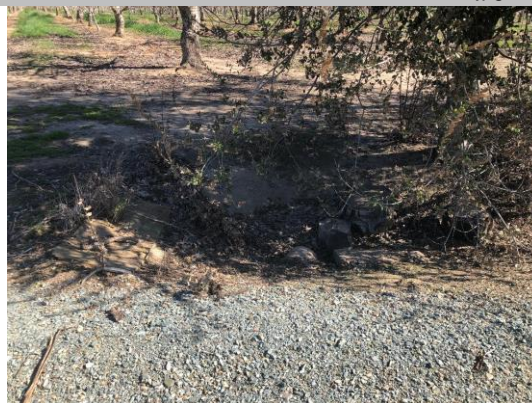
Photo 2 of 3 : UCIP_FA_2021_63205_92450.jpg

LS View: CM pipe at LS toe.

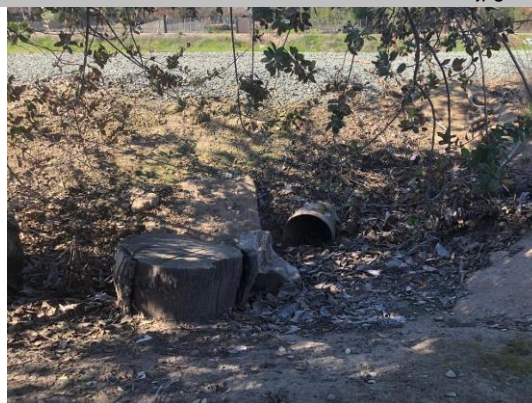
Photo 3 of 3 : UCIP_FA_2021_63205_92451.jpg

LS View: CM pipe at LS toe.

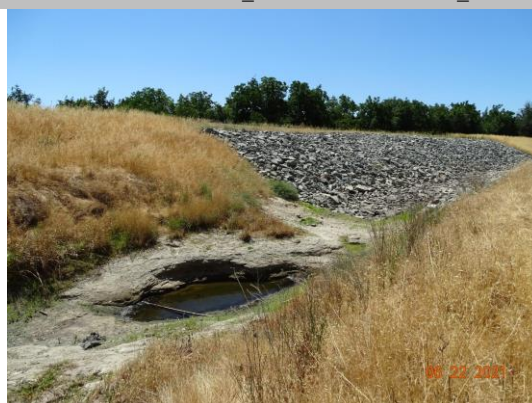
Photo 1 of 2 : SJR2021_NA0017U08RM21.52_2.JPG

06/22/2021: The repair, which extends to the erosion site, is holding up well. No new erosion is visible. The site will be monitored for one more year.

09/08/2020: Visited a PL84-99 erosion repair (most likely DWR 2017 Storm Damage Site LMA-305) that begins at the downstream end of the erosion site, extending 200 ft downstream on both banks.

08/01/2019: Erosion is at the bank toe, caused by river flow.

6/22/2021: View of the upstream end of the repaired erosion site.

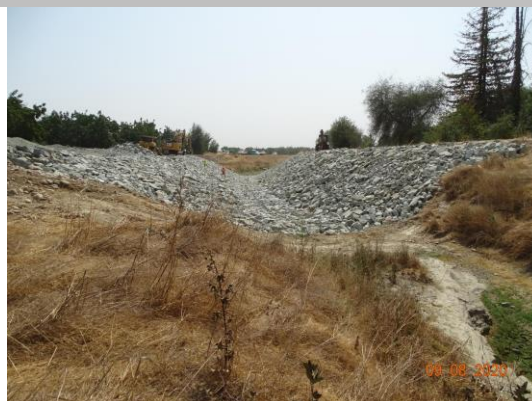
Photo 2 of 2 : SJR2021_NA017U08RM21.52_12.JPG

9/8/2020: Another view of the erosion and upstream end of the repair.

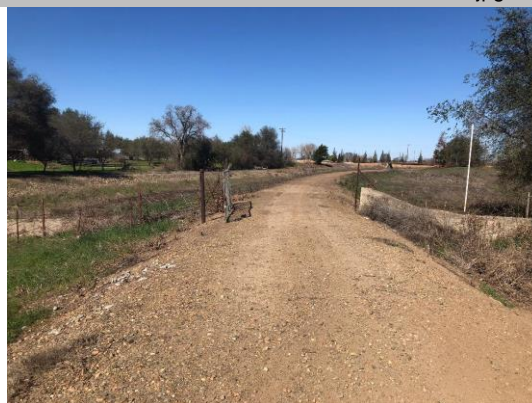
Photo 1 of 3 : UCIP_FA_2021_63824_92394.jpg

DS_ID:23781
FS_ID:63824
EP_NO: N/A
Repair Type: Non-Urgent
EVAL Issue: Unauthorized Encroachment, installed decades prior
Crossing Status: Found
UCIP Comments: 02/23/2021 Record was updated from No Action Needed to Non-Urgent. No permit was found authorizing this encroachment. CVFPB will need to review crossing to determine owner. DWR DMP has not found internal issues, LOF between 1 and 2. Recommend inspection in 5 years. Tree on downstream side of WS headwall is causing slight separation between headwall and apron, 1- to 2-inch gap. The UCIP inspection was completed with LMA representative, J. Caruso. (N. Cholewinski - GEI)
FIELD_STRUCT_DESC: 24-inch corrugated metal drainage pipe through the levee, 6 feet below the crown. Concrete U-shaped headwall on both ends. Flap gate on the waterside (WS) end. Cobble grouted spillway. Cobble grouted inlet on the landside (LS). [Additional Reference(s): DWR Levee Log, 1990. USACE San Joaquin O&M Manual 612.2, 1967, (HLM 15.24)].

Crown Overview

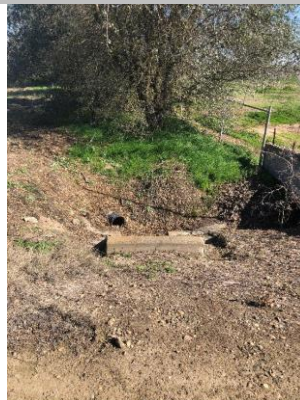
Photo 2 of 3 : UCIP_FA_2021_63824_92397.jpg

LS View: Headwall at LS toe.

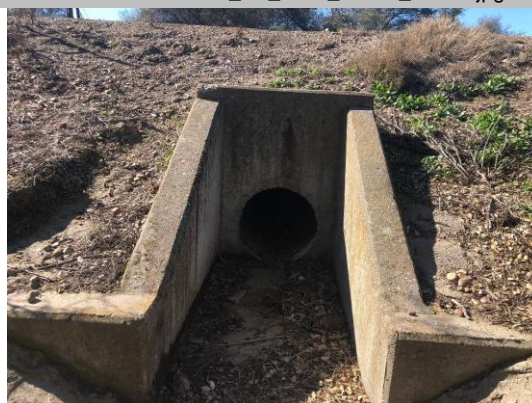
Photo 3 of 3 : UCIP_FA_2021_63824_92398.jpg

LS View: Headwall at LS toe.

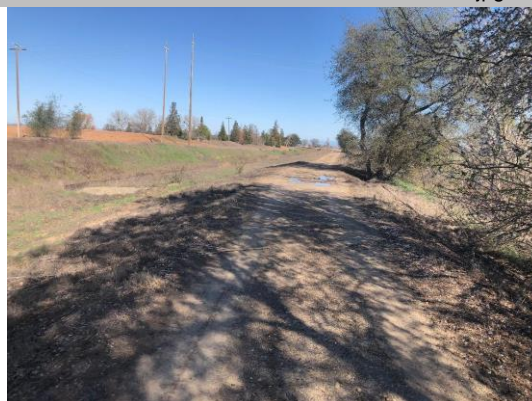
Photo 1 of 3 : UCIP_FA_2021_63826_92358.jpg

Comment Code						
Inspector Comment						
DS_ID:23782 FS_ID:63826 EP_NO: N/A Repair Type: Non-Urgent EVAL Issue: Unauthorized Encroachment, installed decades prior Crossing Status: Found UCIP Comments: 02/23/2021 Record was updated from No Action Needed to Non-Urgent No permit was found authorizing this encroachment. CVFPB will need to review crossing to determine owner. DWR DMP has not found internal issues, LOF between 1 and 2. Recommend inspection in 5 years. The UCIP inspection was completed with LMA representative, J. Caruso. (N. Cholewinski - GEI) FIELD_STRUCT_DESC: 24-inch corrugated metal drainage pipe through the levee, 6 feet below the crown. Concrete U-shaped headwall on both ends. Flap gate on the waterside (WS) end. Cobble grouted spillway. Cobble grouted intake on the landside (LS). [Additional Reference(s): DWR Levee Log, 1990. USACE San Joaquin O&M Manual 612.2, 1967, (HLM 15.44)]. FS Date: 2/23/2021

Crown Overview

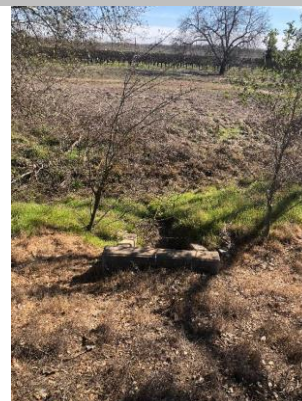
Photo 2 of 3 : UCIP_FA_2021_63826_92359.jpg

LS View

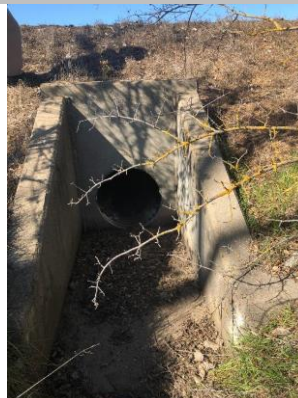
Photo 3 of 3 : UCIP_FA_2021_63826_92360.jpg

LS View: Headwall at LS toe.

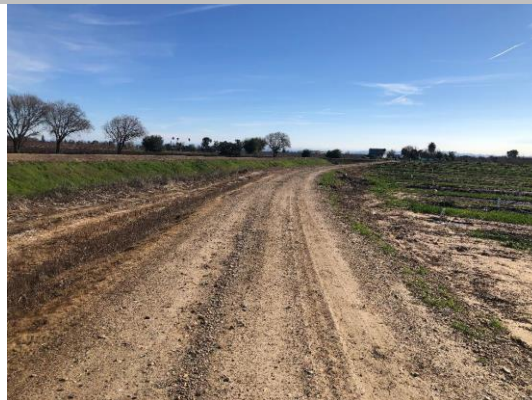
Photo 1 of 3 : UCIP_FA_2021_63835_92186.jpg

Comment Code					
Inspector Comment					
DS_ID:23784 FS_ID:63835 EP_NO: N/A Repair Type: Non-Urgent EVAL Issue: Unauthorized Encroachment, installed decades prior Crossing Status: Found UCIP Comments: 02/25/2021 Record changed from No Action Needed to Non-Urgent. No permit was found authorizing this encroachment. CVFPB will need to review crossing to determine owner. DWR DMP has not found internal issues, LOF between 1 and 2. Recommend inspection in 5 years. Observed slight damage to concrete on LS headwall toe, but no noticeable integrity issues. The UCIP inspection was completed with LMA representative, J. Caruso. (N. Cholewinski - GEI) FIELD_STRUCT_DESC: 24-inch corrugated metal drainage pipe through the levee, 3 feet below the crown. Concrete U-shaped headwall on both ends. Flap gate on the waterside (WS) end. Cobble grouted spillway. Cobble grouted intake on the landside (LS). [Additional Reference(s): DWR Levee Log, 1990. USACE San Joaquin O&M Manual 612.2, 1967, (HLM 16.02)]. FS Date: 2/25/2021

Top of Levee

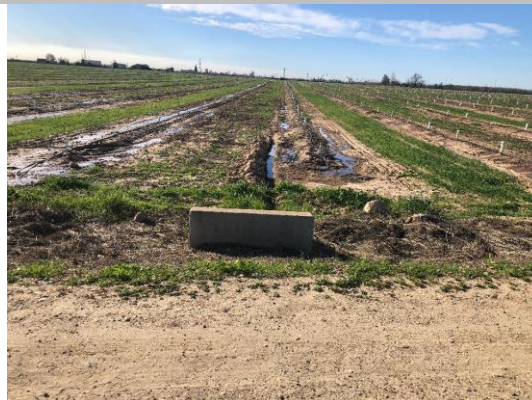
Photo 2 of 3 : UCIP_FA_2021_63835_92187.jpg

LS View

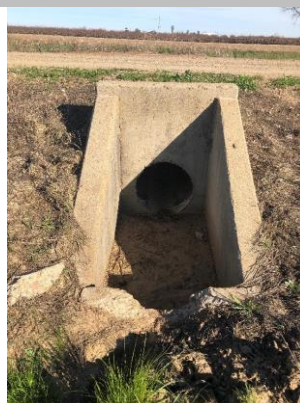
Photo 3 of 3 : UCIP_FA_2021_63835_92188.jpg

LS View: Headwall at LS toe.

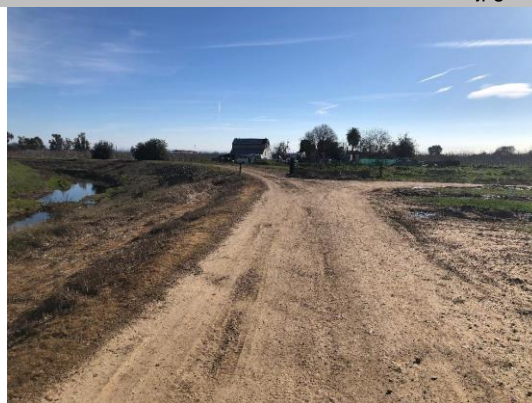
Photo 1 of 3 : UCIP_FA_2021_63836_92179.jpg

DS_ID:23785
 FS_ID:63836
 EP_NO: N/A
 Repair Type: Non-Urgent
 EVAL Issue: Unauthorized Encroachment, installed decades prior
 Crossing Status: Found
 UCIP Comments: 02/25/2021 Record changed from No Action Needed to Non-Urgent. No permit was found authorizing this encroachment. CVFPB will need to review crossing to determine owner. DWR DMP has not found internal issues, LOF between 1 and 2. Recommend inspection in 5 years. The UCIP inspection was completed with LMA representative, J. Caruso. (N. Cholewinski - GEI)
 FIELD_STRUCT_DESC: 24-inch corrugated metal drainage pipe through the levee, 1.5 feet below the crown. Concrete U-shaped headwall on both ends. Flap gate on the waterside (WS) end. Cobble grouted spillway. Cobble grouted intake on the landside (LS).
 [Additional Reference(s): DWR Levee Log, 1990. USACE San Joaquin O&M Manual 612.2, 1967, (HLM 16.15)].
 FS Date: 2/25/2021

Top of Levee

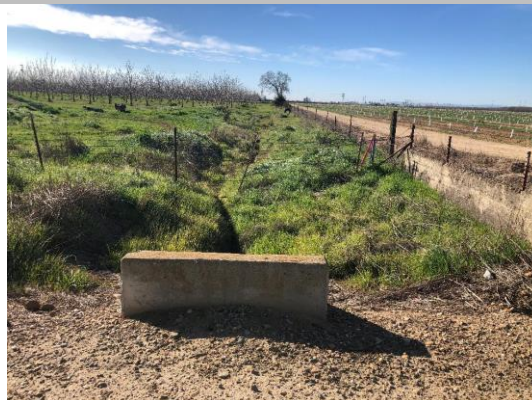
Photo 2 of 3 : UCIP_FA_2021_63836_92180.jpg

LS View

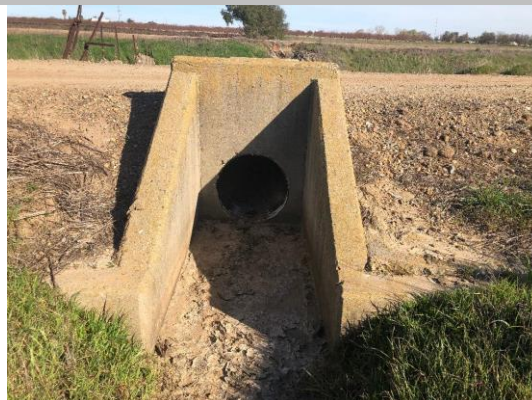
Photo 3 of 3 : UCIP_FA_2021_63836_92181.jpg

LS View: Headwall at LS toe.

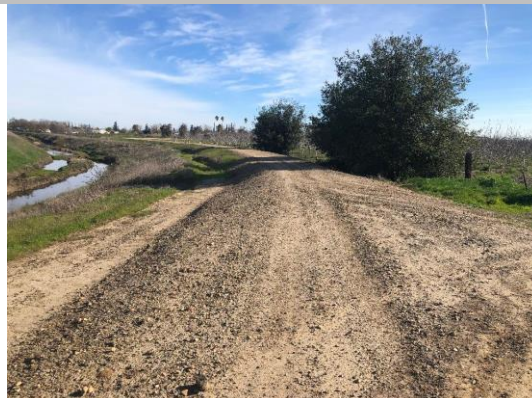
Photo 1 of 3 : UCIP_FA_2021_63068_92169.jpg

Comment Code					
Inspector Comment					
DS_ID:23786 FS_ID:63068 EP_NO: N/A Repair Type: Urgent EVAL Issue: Pipe Integrity Crossing Status: Found UCIP Comments: 02/25/2021 Record was updated from No Action Needed to Urgent due to a corroded through pipe wall at the WS pipe outlet and leakage observed at the LS pipe inlet. DWR DMP has found integrity issues, LOF between 5 and 6. Crossing will be monitored until funding becomes available for removal. No permit was found authorizing this encroachment. CVFPB will need to review crossing to determine owner. An additional 1-inch steel pipe oriented parallel to levee was observed approximately 1 foot adjacent to LS headwall at LS toe. The UCIP inspection was completed with LMA representative, J. Caruso. (N. Cholewinski - GEI) FIELD_STRUCT_DESC: 24-inch corrugated metal drainage pipe through the levee, 8 feet below the crown. Concrete U-shaped headwall on both ends. Flap gate on the waterside (WS) end. Cobble grouted spillway. Cobble grouted intake on the landside (LS). [Additional Reference(s): DWR Levee Log, 1990. USACE San Joaquin O&M Manual 612.2, 1967, (HLM 16.22)]. FS Date: 2/25/2021

Top of Levee

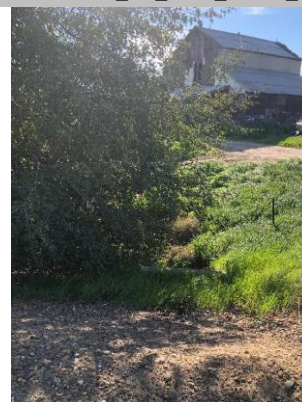
Photo 2 of 3 : UCIP_FA_2021_63068_92170.jpg

LS View

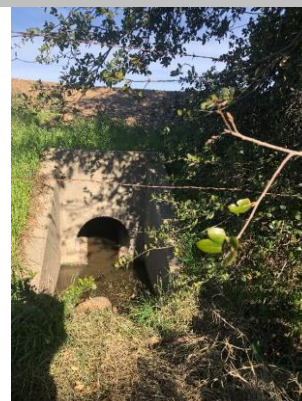
Photo 3 of 3 : UCIP_FA_2021_63068_92171.jpg

Headwall at LS toe.

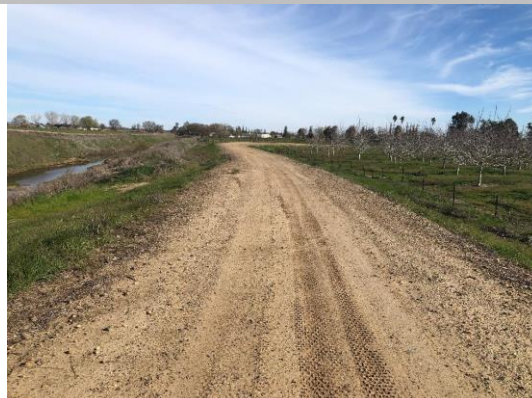
Photo 1 of 3 : UCIP_FA_2021_63837_92159.jpg

Comment Code						
Inspector Comment						
DS_ID:23787 FS_ID:63837 EP_NO: N/A Repair Type: Non-Urgent EVAL Issue: Unauthorized Encroachment, installed decades prior Crossing Status: Found UCIP Comments: 02/25/2021 Record changed from No Action Needed to Non-Urgent. No permit was found authorizing this encroachment. CVFPB will need to review crossing to determine owner. DWR DMP has not found internal issues, LOF between 1 and 2. Recommend inspection in 5 years. The UCIP inspection was completed with LMA representative, J. Caruso. (N. Cholewinski - GEI) FIELD_STRUCT_DESC: 24-inch corrugated metal drainage pipe through the levee, 6 feet below the crown. Concrete U-shaped headwall on both ends. Flap gate on the waterside (WS) end. Cobble grouted spillway. Cobble grouted intake on the landside (LS). [Additional Reference(s): DWR Levee Log, 1990. USACE San Joaquin O&M Manual 612.2, 1967, (HLM 16.27)]. FS Date: 2/25/2021

Crown Overview

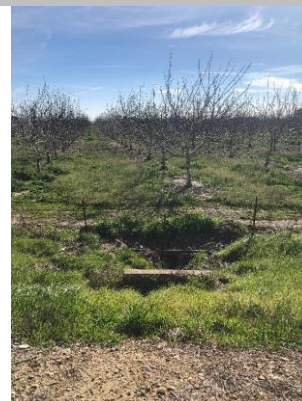
Photo 2 of 3 : UCIP_FA_2021_63837_92161.jpg

LS View

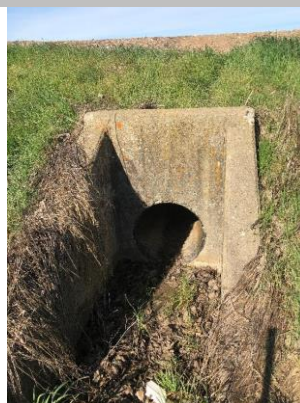
Photo 3 of 3 : UCIP_FA_2021_63837_92162.jpg

Concrete headwall on LS toe.

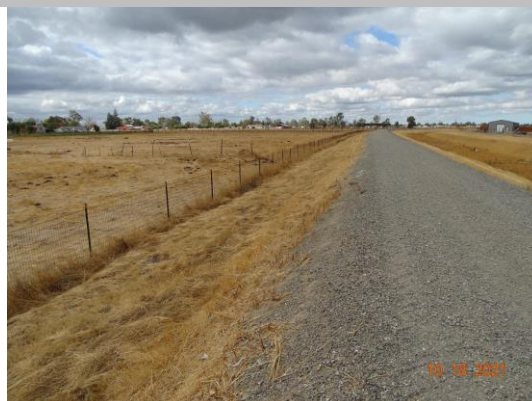
Photo 1 of 1 : FA_2021_NA0017_153_22_20211018_00053.jpg

LM Start	0.00	Rating **	A	Issue No.	22
LM End	1.44	Issue Type +	Ma	Location *	LS
Category	Earthen Levee			GPS Latitude/Longitude	
				Start	End
Item	Vegetation			38.093070 °	38.094043 °
				-121.176422 °	-121.150931 °
DWR ID	DWR_NA0017_09_f_2021_22				
Comment Code					
V1 : Control annual grass and weeds on the levee slopes and easements.					
Inspector Comment

Typical view of well maintained vegetation along the landside slope. Fall 2021

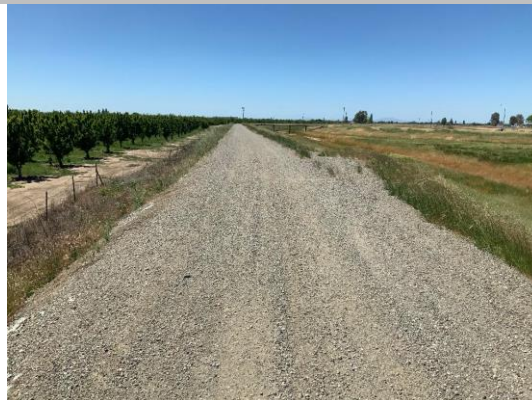
Photo 1 of 3 : UCIP_FA_2021_67121_96876.jpg

Comment Code						
Inspector Comment						
DS_ID:23850 FS_ID:67121 EP_NO: N/A Repair Type: Non-Urgent EVAL Issue: Unauthorized Encroachment, installed decades prior Crossing Status: Found UCIP Comments: 04/27/2021 The record has been upgraded from No Action Needed to Non-Urgent. DWR DMP internal inspection has not found pipe integrity issues. LOF of crossing is less or equal to 4.0. Recommend next inspection in 5 years. No permit was found authorizing this encroachment. CVFPB will need to review crossing to determine owner. The UCIP inspection was completed with LMA representative, J. Nelson. (H. Dunn – GEI) FIELD_STRUCT_DESC: 24-inch CM drainage pipe through the levee, 9.5-feet below the crown. Concrete "U" headwall on both ends. Flap gate on the waterward end. Cobble grouted spillway. Cobble grouted intake on the landward side. O&M Manual Bear Creek Part 2, 1967. Included in O&M Manual Bear Creek Addendum, February 1999. [Additional Reference(s): DWR Levee Log, 1977, 1978, 1987, 1990. USACE San Joaquin O&M Manual Unit 612, Part No. 2 - Bear Creel Project, Unit 7: HLM 7.19 – 16.77, Unit 8: HLM 7.55-16.48, Unit 9: HLM 0.10-1.52; Unit 10: HLM 0.03-1.35, Unit 11: HLM 0.16-3.55, Unit 12: HLM 0.14-3.91; Unit 13, HLM 0.03-1.18; Unit 14, HLM 0.02-1.17, 1967, (HLM 1.52)] FS Date: 4/27/2021

Levee crown looking downstream.
