**Flood Control Project Maintenance
Levee Inspections**

Maintenance Issue Types Only, Levee Inspection Report By Mile - Fall 2021

San Joaquin County Flood Control and Water Conservation District

Waterway	Bank	Unit Miles	Inspection Start/End	Inspector
Unit No. 01 Littlejohn Creek	Left	2.59	10/21/2021 10/21/2021	Alberto De Leon

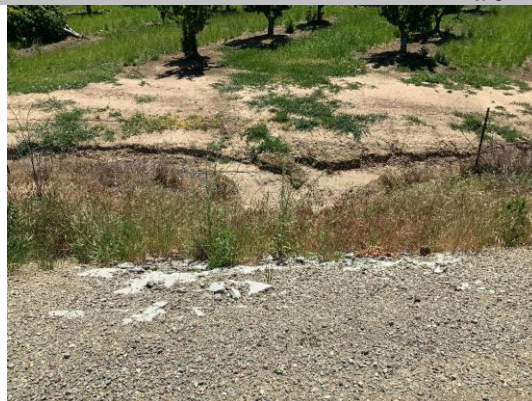
Photo 2 of 3 : UCIP_FA_2021_67121_96877.jpg

Comment Code						
Inspector Comment						
DS_ID:23850 FS_ID:67121 EP_NO: N/A Repair Type: Non-Urgent EVAL Issue: Unauthorized Encroachment, installed decades prior Crossing Status: Found UCIP Comments: 04/27/2021 The record has been upgraded from No Action Needed to Non-Urgent. DWR DMP internal inspection has not found pipe integrity issues. LOF of crossing is less or equal to 4.0. Recommend next inspection in 5 years. No permit was found authorizing this encroachment. CVFPB will need to review crossing to determine owner. The UCIP inspection was completed with LMA representative, J. Nelson. (H. Dunn – GEI) FIELD_STRUCT_DESC: 24-inch CM drainage pipe through the levee, 9.5-feet below the crown. Concrete "U" headwall on both ends. Flap gate on the waterward end. Cobble grouted spillway. Cobble grouted intake on the landward side. O&M Manual Bear Creek Part 2, 1967. Included in O&M Manual Bear Creek Addendum, February 1999. [Additional Reference(s): DWR Levee Log, 1977, 1978, 1987, 1990. USACE San Joaquin O&M Manual Unit 612, Part No. 2 - Bear Creel Project, Unit 7: HLM 7.19 – 16.77, Unit 8: HLM 7.55-16.48, Unit 9: HLM 0.10-1.52; Unit 10: HLM 0.03-1.35, Unit 11: HLM 0.16-3.55, Unit 12: HLM 0.14-3.91; Unit 13, HLM 0.03-1.18; Unit 14, HLM 0.02-1.17, 1967, (HLM 1.52)] FS Date: 4/27/2021

LS view: Toe from crown.

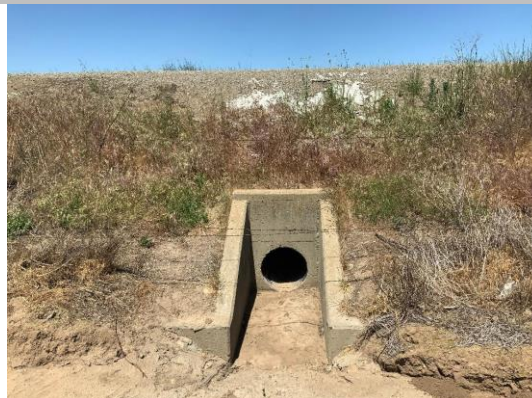
Photo 3 of 3 : UCIP_FA_2021_67121_96878.jpg

LS view: Slope and headwall from toe.

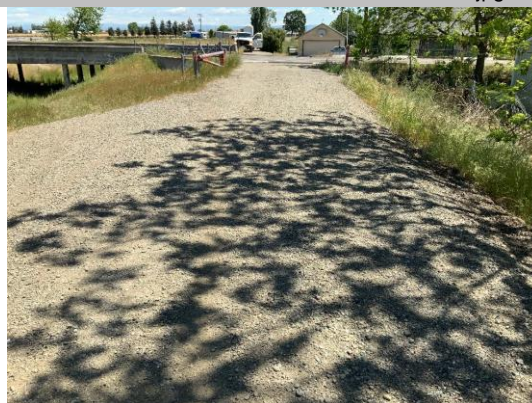
Photo 1 of 3 : UCIP_FA_2021_67123_96893.jpg

Comment Code						
Inspector Comment						
DS_ID:23853 FS_ID:67123 EP_NO: N/A Repair Type: Non-Urgent EVAL Issue: Unauthorized Encroachment, installed decades prior Crossing Status: Found UCIP Comments: 04/27/2021 The record has been upgraded from No Action Needed to Non-Urgent. DWR DMP internal inspection has not found pipe integrity issues. LOF of crossing is less or equal to 4.0. Recommend next inspection in 5 years. No permit was found authorizing this encroachment. CVFPB will need to review crossing to determine owner. The UCIP inspection was completed with LMA representative, J. Nelson. (H. Dunn – GEI) FIELD_STRUCT_DESC: 24-inch corrugated metal drainage pipe through the levee, 4.5 feet below the crown. Flap gate on the waterside (WS) end. Concrete U-shaped headwall on both ends. Cobble grouted spillway. Cobble grouted intake on the landside (LS). [Additional Reference(s): DWR Levee Log, 1987. USACE San Joaquin O&M Manual 612.2, 1967, (HLM 0.56)]. FS Date: 4/27/2021

Levee crown looking upstream.

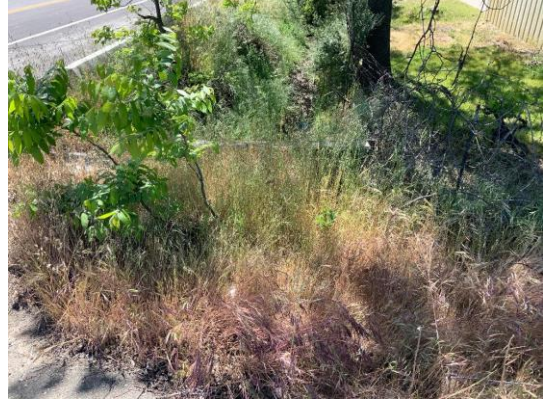
Photo 2 of 3 : UCIP_FA_2021_67123_96894.jpg

LS view: Toe from crown.

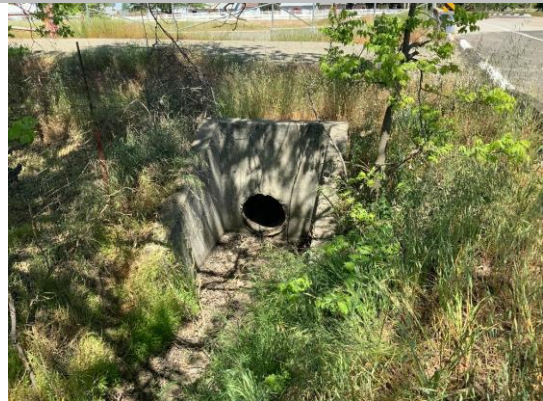
Photo 3 of 3 : UCIP_FA_2021_67123_96895.jpg

LS view: Slope and headwall at toe.

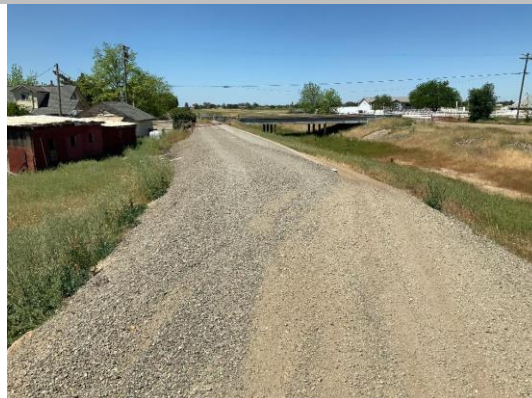
Photo 1 of 3 : UCIP_FA_2021_67124_96901.jpg

Comment Code						
Inspector Comment						
DS_ID:23839 FS_ID:67124 EP_NO: N/A Repair Type: No Action Needed EVAL Issue: Internal Pipe Inspection Crossing Status: Found UCIP Comments: 04/27/2021 Pipe status is still No Action Needed. DWR DMP internal inspection has not found pipe integrity issues. LOF of crossing is less or equal to 4.0. Recommend next inspection in 5 years. The UCIP inspection was completed with LMA representative, J. Nelson. (H. Dunn – GEI) 06/19/2014 Suction hose and appurtenances appear to be abandoned. (W. Wylie - DWR UCIP) FIELD_STRUCT_DESC: 24-inch corrugated metal drainage pipe through the levee, 8 feet below the crown. Concrete U-shaped headwall on both ends. Flap gate on the waterside (WS) end. Cobble grouted spillway. Cobble grouted intake on the landside (LS). Pump with suction hose sleeved through storm drainage pipe located on the LS, removed during winter months. (Suction hose sleeved through pipe under Permit No. 11530, 1976 - Constantine M. Coppulos). [Additional Reference(s): DWR Levee Log, 1987. USACE San Joaquin O&M Manual 612.2, 1967, (HLM 0.62) and 612 (addendum), February 1999, (HLM 0.61) (Station 32+46)]. FS Date: 4/27/2021

Levee crown looking downstream.

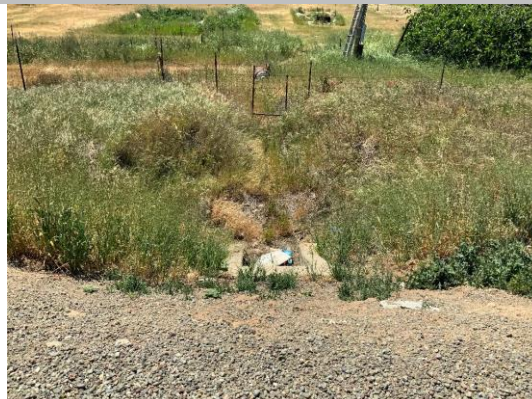
Photo 2 of 3 : UCIP_FA_2021_67124_96902.jpg

LS view: Headwall visible at toe from crown.

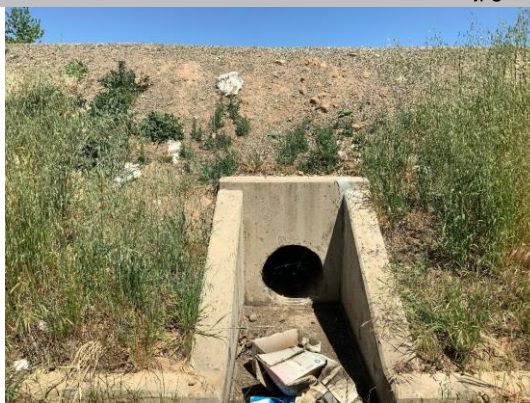
Photo 3 of 3 : UCIP_FA_2021_67124_96903.jpg

LS view: Slope and headwall at toe.

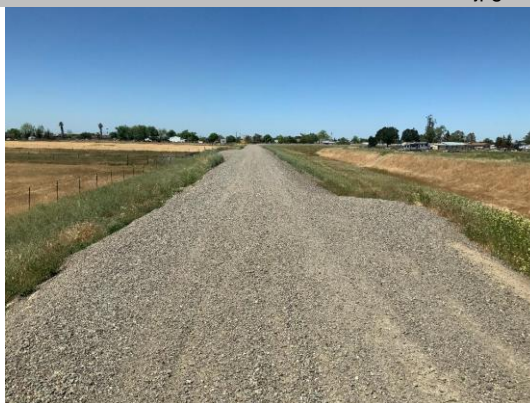
Photo 1 of 3 : UCIP_FA_2021_67125_96906.jpg

DS_ID:23840
FS_ID:67125
EP_NO: N/A
Repair Type: Non-Urgent
EVAL Issue: Limited Inspection/No UCIP Evaluation
Crossing Status: Found
UCIP Comments: 04/27/2021 The record has been upgraded from No Action Needed to Non-Urgent. Did not inspect LS headwall due to steep slope and slippery rubble. DWR DMP internal inspection has not found pipe integrity issues. LOF of crossing is less or equal to 4.0. Recommend next inspection in 5 years. No permit was found authorizing this encroachment. CVFPB will need to review crossing to determine owner. The UCIP inspection was completed with LMA representative, J. Nelson. (H. Dunn – GEI)
FIELD_STRUCT_DESC: 24-inch corrugated metal drainage pipe through the levee, 7 feet below the crown. Concrete U-shaped headwall on both ends. Flap gate on the waterside (WS) end. Cobble grouted spillway. Cobble grouted intake on the landside (LS). [Additional Reference(s): DWR Levee Log, 1987. USACE San Joaquin O&M Manual 612.2, 1967, (HLM 0.86)].

Levee crown looking downstream.

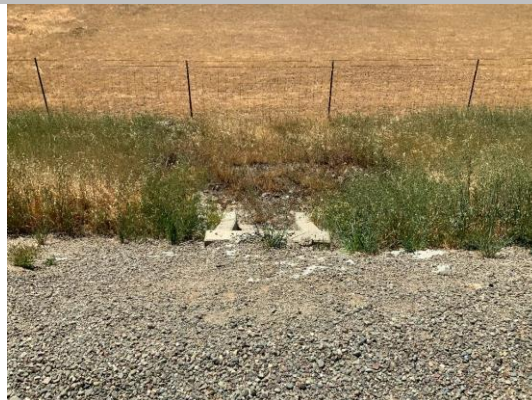
Photo 2 of 3 : UCIP_FA_2021_67125_96907.jpg

LS view: Headwall visible at toe from crown.

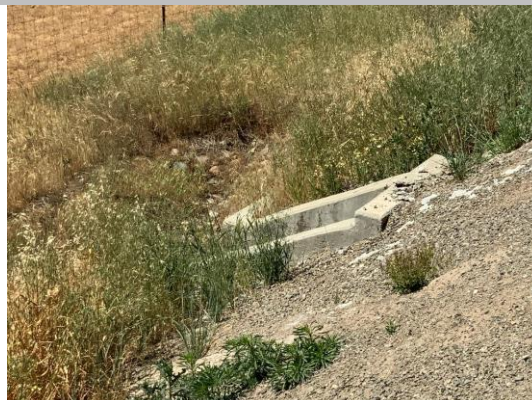
Photo 3 of 3 : UCIP_FA_2021_67125_96905.jpg

LS view: Slope and headwall from crown.

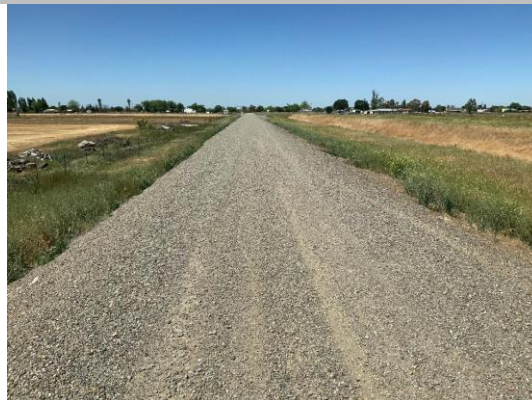
Photo 1 of 3 : UCIP_FA_2021_67126_96917.jpg

Comment Code					
Inspector Comment					
DS_ID:23841 FS_ID:67126 EP_NO: N/A Repair Type: Non-Urgent EVAL Issue: Pipe Damage Crossing Status: Found UCIP Comments: 04/27/2021 Pipe status is still Non-Urgent. DWR DMP internal inspection has found pipe integrity issues. LOF of crossing is between 4.1 and 5. Crossing will be monitored until funding becomes available for rehabilitation. No permit was found authorizing this encroachment. CVFPB will need to review crossing to determine owner. The UCIP inspection was completed with LMA representative, J. Nelson. (H. Dunn – GEI) 06/19/2014 Sediment buildup inside pipe. (W. Wylie -DWR UCIP) FIELD_STRUCT_DESC: 12-inch corrugated metal storm drainage pipe through the levee, 7 feet below the crown. Headwall on the landside (LS) toe. Flap gate on the waterside (WS) end. Cobble grouted spillway. [Additional Reference(s): DWR Levee Log, 1987. USACE San Joaquin O&M Manual 612 (addendum), February 1999, (HLM 0.93) (Station 49+30)]. FS Date: 4/27/2021

Levee crown looking downstream.

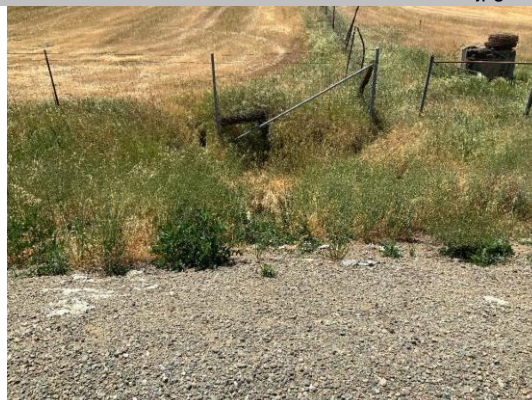
Photo 2 of 3 : UCIP_FA_2021_67126_96919.jpg

LS view: Toe from crown.

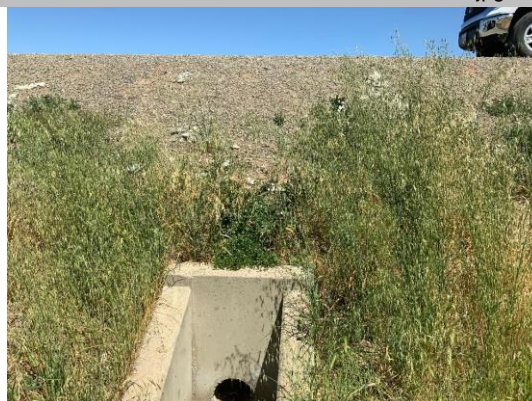
Photo 3 of 3 : UCIP_FA_2021_67126_96920.jpg

LS view: Slope from toe.

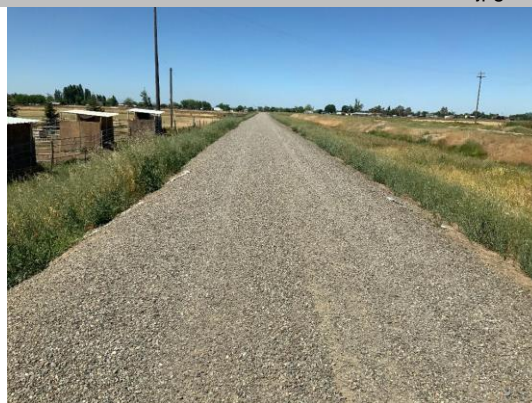
Photo 1 of 3 : UCIP_FA_2021_67127_96928.jpg

DS_ID:23842
FS_ID:67127
EP_NO: N/A
Repair Type: Urgent
EVAL Issue: Pipe Integrity
Crossing Status: Found
UCIP Comments: 04/27/2021 The record has been upgraded from No Action Needed to Urgent. DWR DMP internal inspection has found pipe integrity issues. LOF of crossing is between 5 and 6. Crossing will be monitored until funding becomes available to address the issues. No permit was found authorizing this encroachment. CVFPB will need to review crossing to determine owner. The UCIP inspection was completed with LMA representative, J. Nelson. (H. Dunn – GEI)
FIELD_STRUCT_DESC: 12-inch corrugated metal drainage pipe through the levee, 6 feet below the crown. Flap gate on the waterside (WS) end. Cobble grouted spillway. [Additional Reference(s): DWR Levee Log, 1987. USACE San Joaquin O&M Manual 612.2, 1967, (HLM 1.03)].
FS Date: 4/27/2021

Levee crown looking downstream.

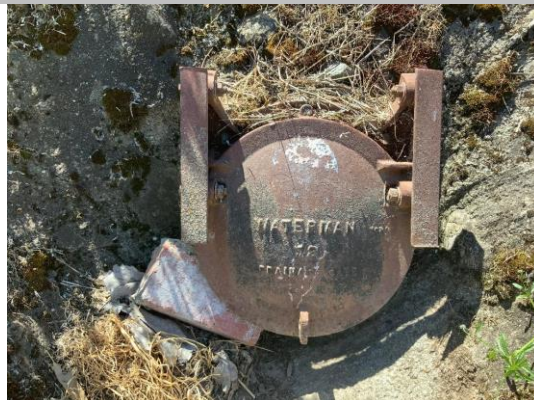
Photo 2 of 3 : UCIP_FA_2021_67127_96929.jpg

WS view: Close up of flapgate at toe.

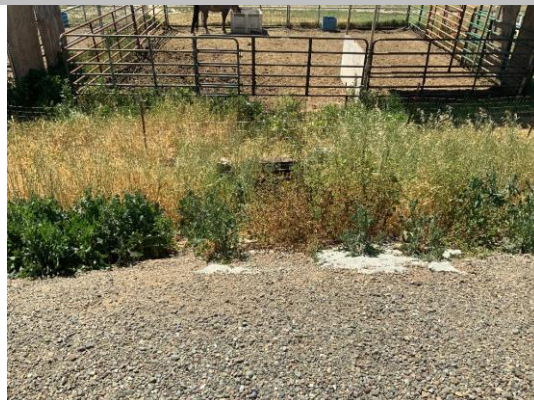
Photo 3 of 3 : UCIP_FA_2021_67127_96930.jpg

LS view: Toe from crown.

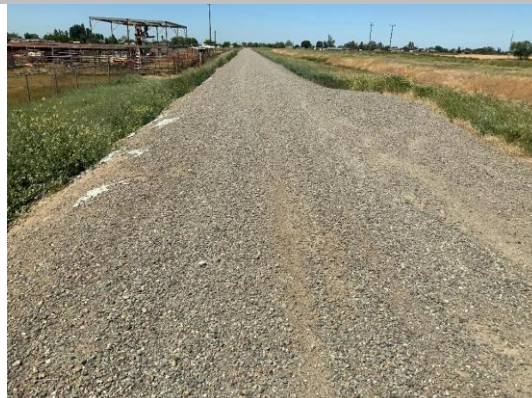
Photo 1 of 3 : UCIP_FA_2021_67128_96936.jpg

Comment Code					
Inspector Comment					
DS_ID:23843 FS_ID:67128 EP_NO: N/A Repair Type: Non-Urgent EVAL Issue: Unauthorized Encroachment, installed decades prior Crossing Status: Found UCIP Comments: 04/27/2021 The record has been upgraded from No Action Needed to Non-Urgent. DWR DMP internal inspection has not found pipe integrity issues. LOF of crossing is less or equal to 4.0. Recommend next inspection in 5 years. No permit was found authorizing this encroachment. CVFPB will need to review crossing to determine owner. The UCIP inspection was completed with LMA representative, J. Nelson. (H. Dunn – GEI) FIELD_STRUCT_DESC: 24-inch corrugated metal drainage pipe through the levee, 4.5 feet below the crown. Concrete U-shaped headwall on both ends. Flap gate on the waterside (WS) end. One corrugated metal cutoff wall. Cobble grouted spillway. Cobble grouted intake on the landside (LS). [Additional Reference(s): DWR Levee Log, 1987. USACE San Joaquin O&M Manual 612.2, 1967, (HLM 1.09) and 612 (addendum), February 1999, (HLM 1.09) (Station 57+30)]. FS Date: 4/27/2021

Levee crown looking downstream.

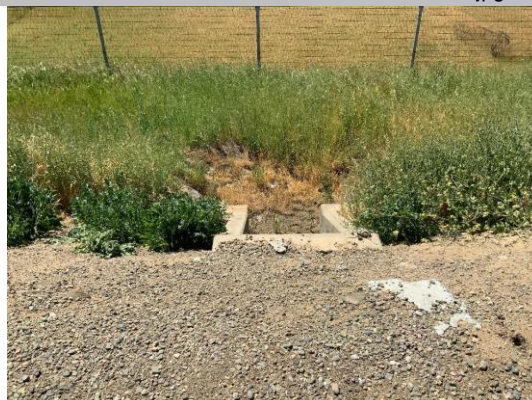
Photo 2 of 3 : UCIP_FA_2021_67128_96937.jpg

LS view: Headwall visible at toe from crown.

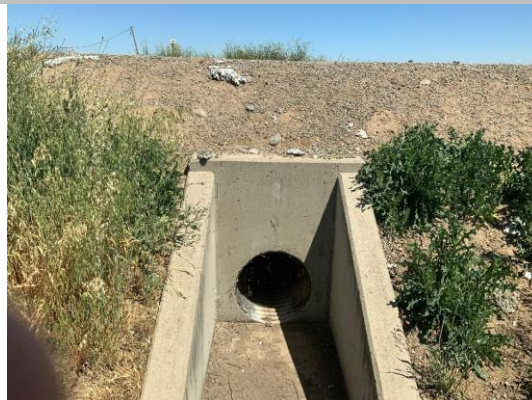
Photo 3 of 3 : UCIP_FA_2021_67128_96938.jpg

LS view: Slope and headwall at toe.

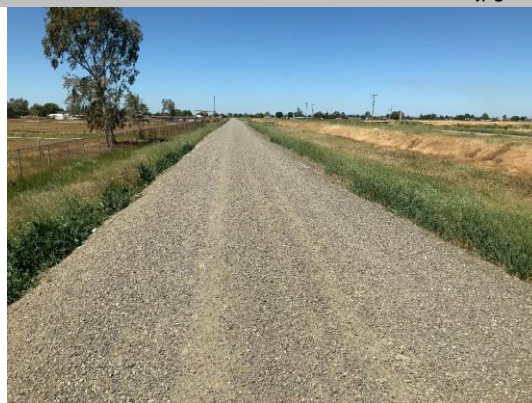
Photo 1 of 3 : UCIP_FA_2021_67129_96942.jpg

Levee crown looking downstream.

Comment Code					
Inspector Comment					
DS_ID:23844 FS_ID:67129 EP_NO: N/A Repair Type: Urgent EVAL Issue: Pipe Integrity Crossing Status: Found UCIP Comments: 04/27/2021 The record has been upgraded from No Action Needed to Urgent. DWR DMP internal inspection has found pipe integrity issues. LOF of crossing is between 5 and 6. Crossing will be monitored until funding becomes available to address the issues. No permit was found authorizing this encroachment. CVFPB will need to review crossing to determine owner. The UCIP inspection was completed with LMA representative, J. Nelson. (H. Dunn – GEI) FIELD_STRUCT_DESC: 12-inch corrugated metal drainage pipe through the levee, 7 feet below the crown. Headwall on the landside (LS) toe. Flap gate on the waterside (WS) end. Cobble grouted spillway. [Additional Reference(s): DWR Levee Log, 1987. USACE San Joaquin O&M Manual 612.2, 1967, (HLM 1.18) and 612 (addendum), February 1999, (HLM 1.17) (Station 61+82)]. FS Date: 4/27/2021

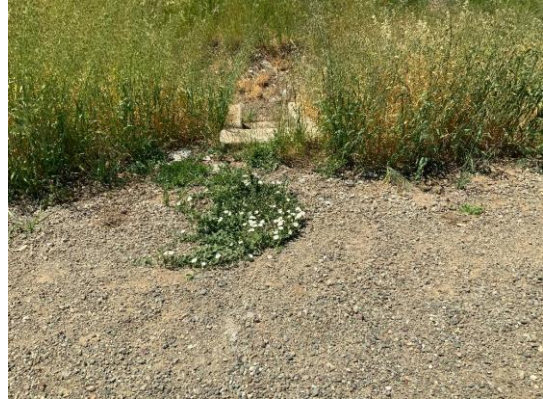
Photo 2 of 3 : UCIP_FA_2021_67129_96944.jpg

LS view: Headwall visible at toe from crown.

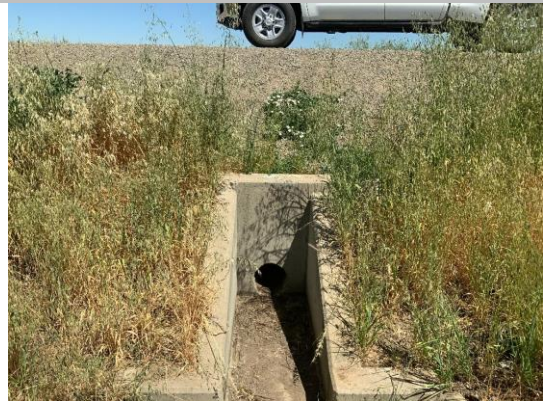
Photo 3 of 3 : UCIP_FA_2021_67129_96945.jpg

LS view: Slope and headwall at toe.

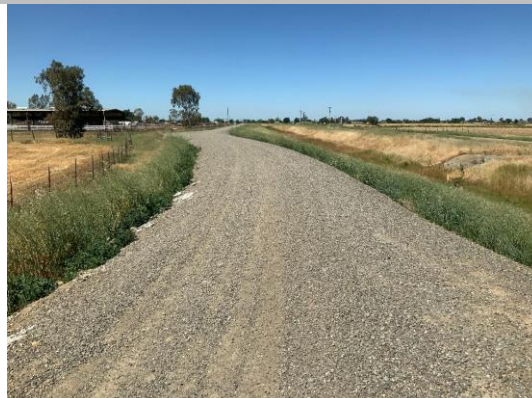
Photo 1 of 3 : UCIP_FA_2021_67130_96949.jpg

Comment Code						
Inspector Comment						
DS_ID:23845 FS_ID:67130 EP_NO: N/A Repair Type: Non-Urgent EVAL Issue: Unauthorized Encroachment, installed decades prior Crossing Status: Found UCIP Comments: 04/27/2021 The record has been upgraded from No Action Needed to Non-Urgent. DWR DMP internal inspection has not found pipe integrity issues. LOF of crossing is less or equal to 4.0. Recommend next inspection in 5 years. No permit was found authorizing this encroachment. CVFPB will need to review crossing to determine owner. The UCIP inspection was completed with LMA representative, J. Nelson. (H. Dunn – GEI) FIELD_STRUCT_DESC: 12-inch corrugated metal storm drainage pipe through the levee, 6.5 feet below the crown. Flap gate on the waterside (WS) end. Cobble grouted spillway. [Additional Reference(s): DWR Levee Log, 1987. USACE San Joaquin O&M Manual 612.2, 1967, (HLM 1.23) and 612 (addendum), February 1999, (HLM 1.23) (Station 64+78)]. FS Date: 4/27/2021

Levee crown looking downstream.

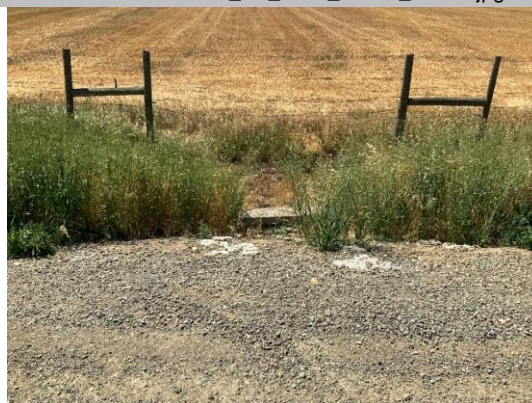
Photo 2 of 3 : UCIP_FA_2021_67130_96950.jpg

LS view: Headwall visible at toe from crown.

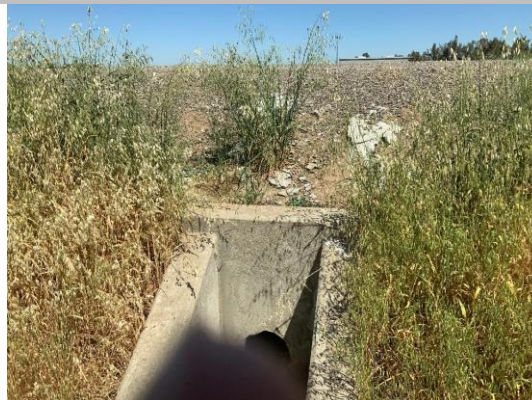
Photo 3 of 3 : UCIP_FA_2021_67130_96951.jpg

LS view: Slope and headwall at toe.

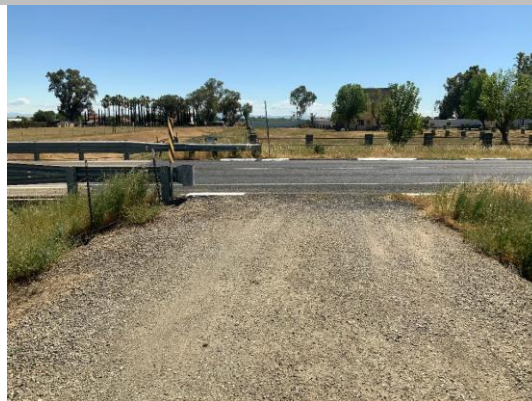
Photo 1 of 3 : UCIP_FA_2021_67331_96963.jpg

DS_ID:23847
 FS_ID:67331
 EP_NO: N/A
 Repair Type: Non-Urgent
 EVAL Issue: Limited Inspection/No UCIP Evaluation
 Crossing Status: Found
 UCIP Comments: 04/27/2021 Pipe status is still Non-Urgent. Barbed wire limiting closeup inspection of WS flapgate, but looked fine from afar. DWR DMP internal inspection has not found pipe integrity issues. LOF of crossing is less or equal to 4.0. Recommend next inspection in 5 years. No permit was found authorizing this encroachment. CVFPB will need to review crossing to determine owner. The UCIP inspection was completed with LMA representative, J. Nelson. (H. Dunn – GEI)

06/19/2014 Flapgate blocked by soil and possibly concrete on WS slope. (W. Wylie - DWR UCIP)
 FIELD_STRUCT_DESC: 21-inch corrugated metal drainage pipe through the levee, 5.5 feet below the crown. Flap gate on the waterside (WS) end. Cobble grouted spillway. [Additional Reference(s): DWR Levee Log, 1987. USACE San Joaquin O&M Manual 612.2, 1967, (HLM 1.45) and 612 (addendum), February 1999, (HLM 1.45) (Station 76+42)].
 FS Date: 4/27/2021

Levee crown looking upstream.

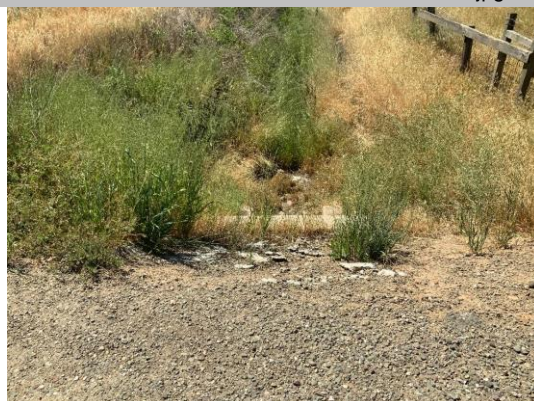
Photo 2 of 3 : UCIP_FA_2021_67331_96966.jpg

LS view: Headwall visible at toe from crown.

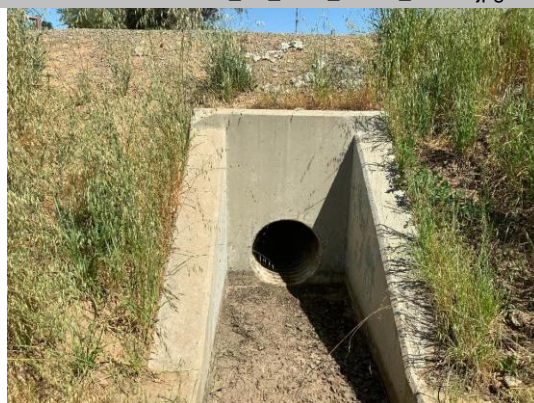
Photo 3 of 3 : UCIP_FA_2021_67331_96961.jpg

LS view: Slope and headwall at toe.

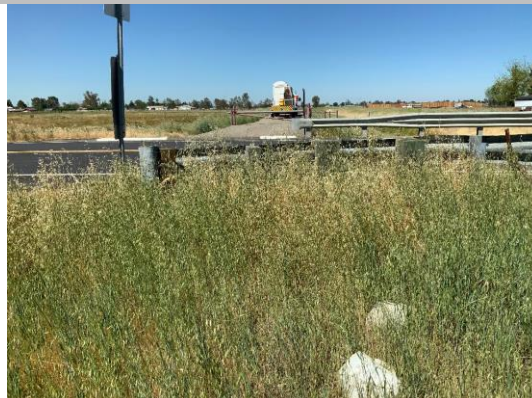
Photo 1 of 3 : UCIP_FA_2021_67133_96969.jpg

Comment Code						
Inspector Comment						
DS_ID:23848 FS_ID:67133 EP_NO: N/A Repair Type: Non-Urgent EVAL Issue: Pipe Damage Crossing Status: Found UCIP Comments: 04/27/2021 The record has been upgraded from No Action Needed to Non-Urgent. DWR DMP internal inspection has found pipe integrity issues. LOF of crossing is between 4.1 and 5. Crossing will be monitored until funding becomes available for rehabilitation. WS pipe edges midly warped. No permit was found authorizing this encroachment. CVFPB will need to review crossing to determine owner. The UCIP inspection was completed with LMA representative, J. Nelson. (H. Dunn – GEI) FIELD_STRUCT_DESC: 21-inch corrugated metal drainage pipe through the levee, 4 feet below the crown. Flap gate on the waterside (WS) end. Cobble grouted spillway. [Additional Reference(s): DWR Levee Log, 1987. USACE San Joaquin O&M Manual 612.2, 1967, (HLM 1.47)]. FS Date: 4/27/2021

Levee crown looking downstream.

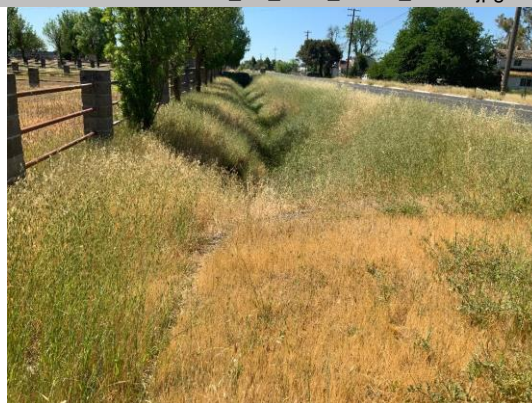
Photo 2 of 3 : UCIP_FA_2021_67133_96970.jpg

LS view: Toe from crown.

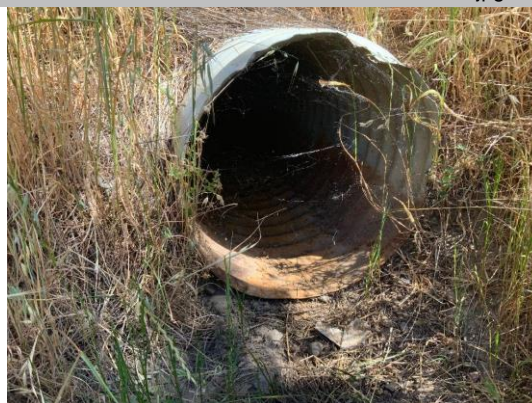
Photo 3 of 3 : UCIP_FA_2021_67133_96971.jpg

LS view: Close up of pipe inlet at toe, minor warping on edges.

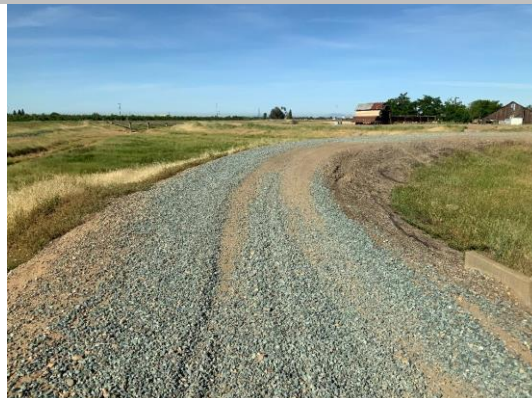
Photo 1 of 3 : UCIP_FA_2021_66859_97221.jpg

Comment Code					
Inspector Comment					
DS_ID:23859 FS_ID:66859 EP_NO: N/A Repair Type: Non-Urgent EVAL Issue: Unauthorized Encroachment, installed decades prior Crossing Status: Found UCIP Comments: 04/29/2021 The record has been upgraded from No Action Needed to Non-Urgent. DWR DMP internal inspection has not found pipe integrity issues. LOF of crossing is less or equal to 4.0. Recommend inspection in 5 years. No permit was found authorizing this encroachment. CVFPB will need to review crossing to determine owner. The UCIP inspection was completed with LMA representative, J. Nelson. (H. Dunn – GEI) FIELD_STRUCT_DESC: 36-inch corrugated metal drainage pipe through the levee, 7 feet below the crown. Concrete U-shaped headwall on both ends. Flap gate on the waterside (WS) end. Cobble grouted spillway. Cobble grouted intake on the landside (LS). [Additional Reference(s): DWR Levee Log, 1978. USACE San Joaquin O&M Manual 612.2, 1967, (HLM 0.03)]. FS Date: 4/29/2021

Levee crown looking downstream.

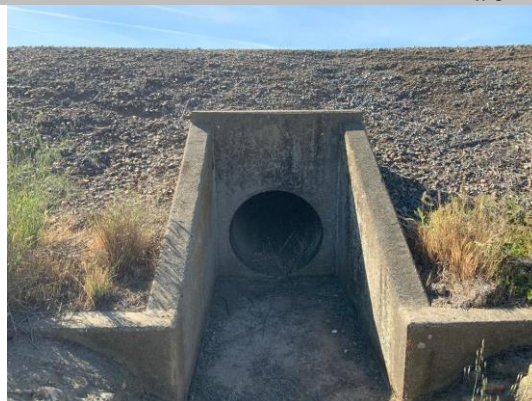
Photo 2 of 3 : UCIP_FA_2021_66859_97222.jpg

LS view: Slope and headwall at toe.

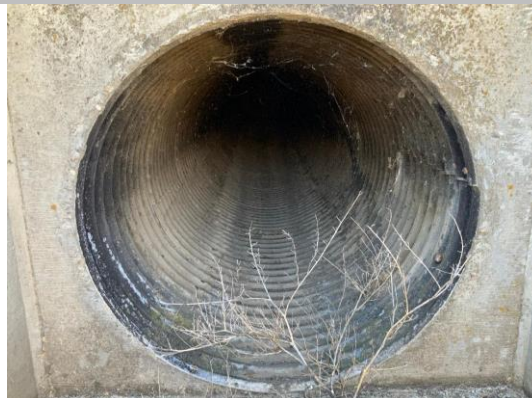
Photo 3 of 3 : UCIP_FA_2021_66859_97223.jpg

LS view: Close up of pipe inlet at toe.

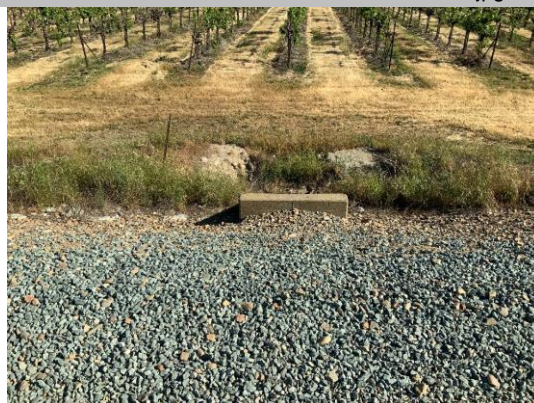
Photo 2 of 3 : UCIP_FA_2021_66860_97227.jpg

DS_ID:23860
FS_ID:66860
EP_NO: N/A
Repair Type: Non-Urgent
EVAL Issue: Unauthorized Encroachment, installed decades prior
Crossing Status: Found
UCIP Comments: 04/29/2021 The record has been upgraded from No Action Needed to Non-Urgent. DWR DMP internal inspection has not found pipe integrity issues. LOF of crossing is less or equal to 4.0. Recommend inspection in 5 years. No permit was found authorizing this encroachment. CVFPB will need to review crossing to determine owner. The UCIP inspection was completed with LMA representative, J. Nelson. (H. Dunn – GEI)
FIELD_STRUCT_DESC: 24-inch corrugated metal drainage pipe through the levee, 7 feet below the crown. Concrete U-shaped headwall on both ends. Flap gate on the waterside (WS) end. Cobble grouted spillway. Cobble grouted intake on the landside (LS). [Additional Reference(s): DWR Levee Log, 1978. USACE San Joaquin O&M Manual 612.2, 1967, (HLM 0.24)].

LS view: Headwall visible at toe from crown.

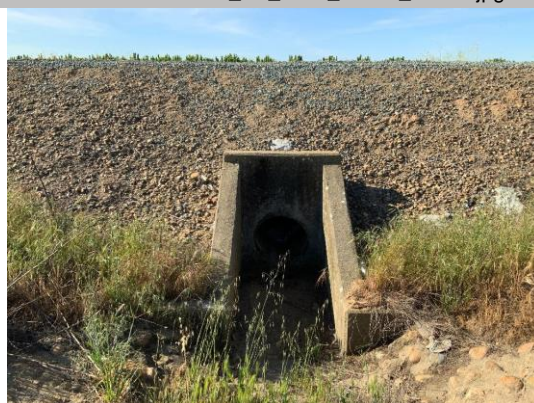
Photo 3 of 3 : UCIP_FA_2021_66860_97228.jpg

LS view: Slope and headwall at toe.

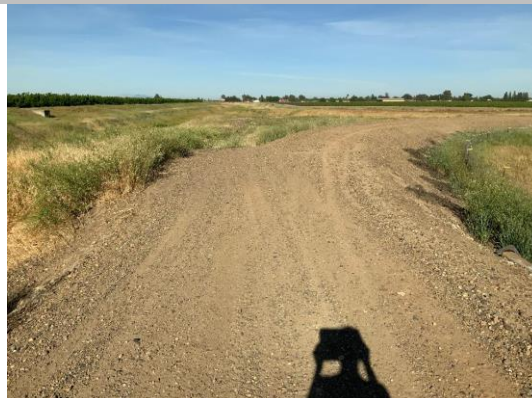
Photo 1 of 3 : UCIP_FA_2021_66861_97235.jpg

Comment Code					
Inspector Comment					
DS_ID:23861 FS_ID:66861 EP_NO: N/A Repair Type: Non-Urgent EVAL Issue: Unauthorized Encroachment, installed decades prior Crossing Status: Found UCIP Comments: 04/29/2021 The record has been upgraded from No Action Needed to Non-Urgent. DWR DMP internal inspection has not found pipe integrity issues. LOF of crossing is less or equal to 4.0. Recommend inspection in 5 years. No permit was found authorizing this encroachment. CVFPB will need to review crossing to determine owner. The UCIP inspection was completed with LMA representative, J. Nelson. (H. Dunn – GEI) FIELD_STRUCT_DESC: 24-inch corrugated metal drainage pipe through the levee, 5 feet below the crown. Concrete U-shaped headwall on both ends. Flap gate on the waterside (WS) end. Cobble grouted spillway. Cobble grouted intake on the landside (LS). [Additional Reference(s): DWR Levee Log, 1978. USACE San Joaquin O&M Manual 612.2, 1967, (HLM 0.36)]. FS Date: 4/29/2021

Levee crown looking downstream.

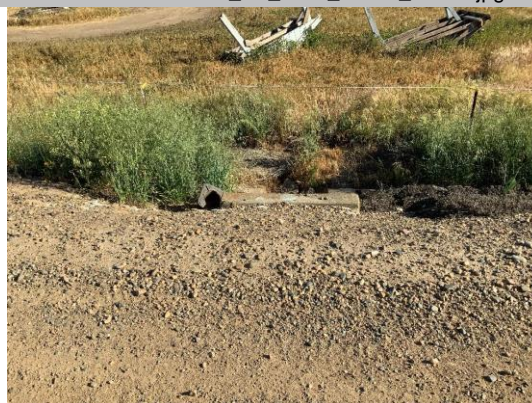
Photo 2 of 3 : UCIP_FA_2021_66861_97236.jpg

LS view: Headwall visible at toe from crown.

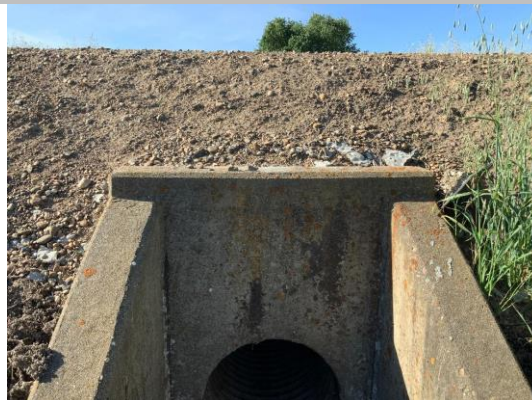
Photo 3 of 3 : UCIP_FA_2021_66861_97237.jpg

LS view: Slope and headwall at toe.

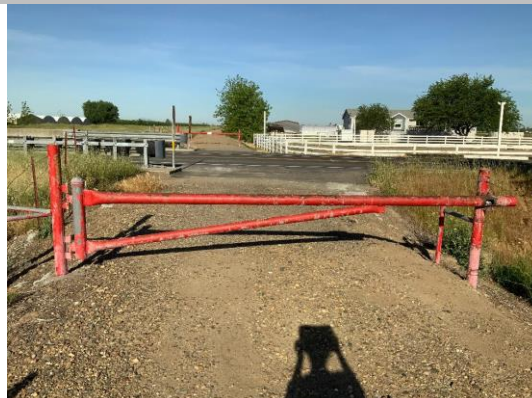
Photo 1 of 3 : UCIP_FA_2021_66862_97247.jpg

Comment Code						
Inspector Comment						
DS_ID:23863 FS_ID:66862 EP_NO: N/A Repair Type: Non-Urgent EVAL Issue: Unauthorized Encroachment, installed decades prior Crossing Status: Found UCIP Comments: 04/29/2021 The record has been upgraded from No Action Needed to Non-Urgent. DWR DMP internal inspection has not found pipe integrity issues. LOF of crossing is less or equal to 4.0. Something is peeling away inside the pipe inlet, possibly just the liner. No permit was found authorizing this encroachment. CVFPB will need to review crossing to determine owner. The UCIP inspection was completed with LMA representative, J. Nelson. (H. Dunn – GEI) FIELD_STRUCT_DESC: 24-inch corrugated metal drainage pipe through the levee, 4 feet below the crown. Concrete U-shaped headwall on both ends. Flap gate on the waterside (WS) end. Cobble grouted spillway. Cobble grouted intake on the landside (LS). [Additional Reference(s): DWR Levee Log, 1978. USACE San Joaquin O&M Manual 612.2, 1967, (HLM 0.46)]. FS Date: 4/29/2021

Levee crown looking downstream.

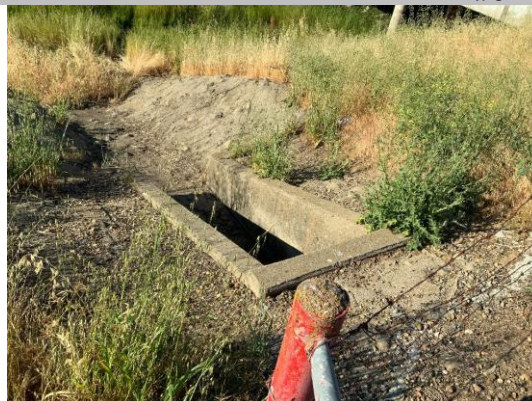
Photo 2 of 3 : UCIP_FA_2021_66862_97248.jpg

WS view: Headwall visible at toe from crown.

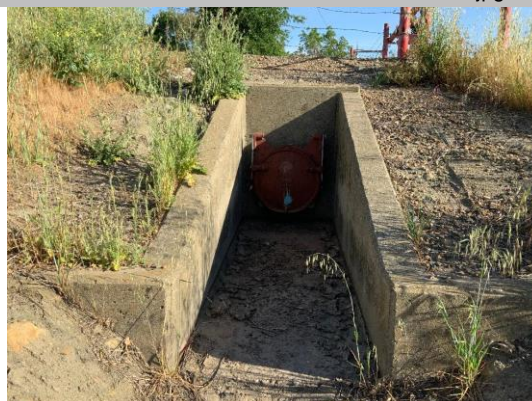
Photo 3 of 3 : UCIP_FA_2021_66862_97249.jpg

WS view: Slope, headwall, and flapgate at toe.

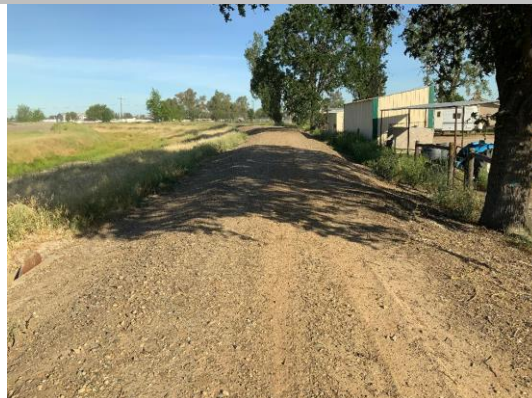
Photo 1 of 3 : UCIP_FA_2021_66863_97258.jpg

Comment Code					
Inspector Comment					
DS_ID:23864 FS_ID:66863 EP_NO: N/A Repair Type: Non-Urgent EVAL Issue: Unauthorized Encroachment, installed decades prior Crossing Status: Found UCIP Comments: 04/29/2021 The record has been upgraded from No Action Needed to Non-Urgent. DWR DMP internal inspection has not found pipe integrity issues. LOF of crossing is less or equal to 4.0. Recommend inspection in 5 years. No permit was found authorizing this encroachment. CVFPB will need to review crossing to determine owner. The UCIP inspection was completed with LMA representative, J. Nelson. (H. Dunn – GEI) FIELD_STRUCT_DESC: 24-inch corrugated metal drainage pipe through the levee, 5 feet below the crown. Concrete U-shaped headwall on both ends. Flap gate on the waterside (WS) end. Cobble grouted spillway. Cobble grouted intake on the landside (LS). (Temporary 3-inch polyvinyl chloride drainage pipe sleeved through drainage pipe with portable LS pump under Permit No. 11617, 1976 - Tom Patterson). [Additional Reference(s): DWR Levee Log, 1978. USACE San Joaquin O&M Manual 612.2, 1967, (HLM 0.58)]. FS Date: 4/29/2021

Levee crown looking downstream.

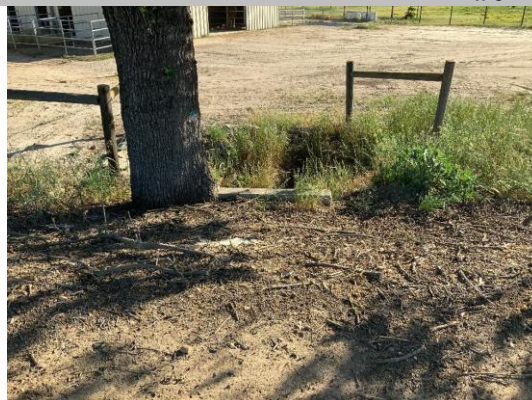
Photo 2 of 3 : UCIP_FA_2021_66863_97259.jpg

LS view: Headwall visible at toe from crown.

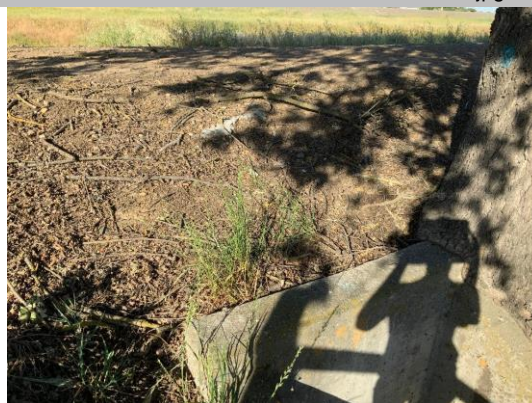
Photo 3 of 3 : UCIP_FA_2021_66863_97260.jpg

LS view: Slope above headwall from toe.

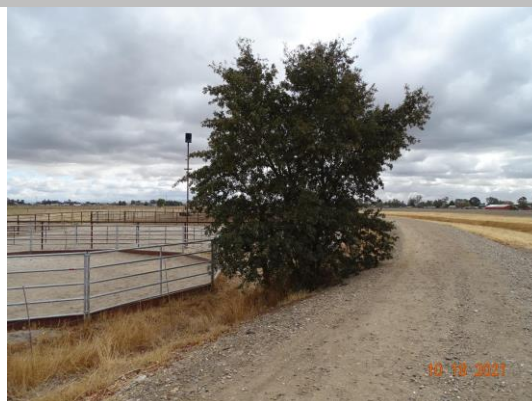
Photo 1 of 1 : FA_2021_NA0017_154_15_20211018_00037.jpg

LM Start	0.59	Rating **	M	Issue No.	15
LM End	0.59	Issue Type +	Ma	Location *	LS
Category	Earthen Levee			GPS Latitude/Longitude	
				Start	End
Item	Trim / Thin Trees			38.094690 °	38.094690 °
				-121.164339 °	-121.164339 °
DWR ID	DWR_NA0017_10_s_2019_15				
Comment Code					
T3 : Trim and thin trees to allow visibility of the ground and room to flood fight.					
Inspector Comment

View of untrimmed tree along the landside slope. Fall 2021

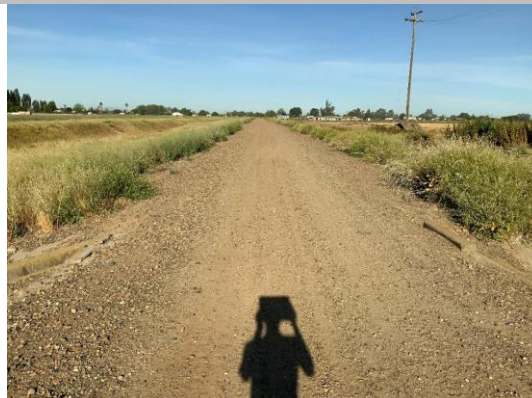
Photo 1 of 3 : UCIP_FA_2021_66864_97264.jpg

Comment Code						
Inspector Comment						
DS_ID:23865 FS_ID:66864 EP_NO: N/A Repair Type: Non-Urgent EVAL Issue: Unauthorized Encroachment, installed decades prior Crossing Status: Found UCIP Comments: 04/29/2021 The record has been upgraded from No Action Needed to Non-Urgent. DWR DMP internal inspection has not found pipe integrity issues. LOF of crossing is less or equal to 4.0. Recommend inspection in 5 years. No permit was found authorizing this encroachment. CVFPB will need to review crossing to determine owner. The UCIP inspection was completed with LMA representative, J. Nelson. (H. Dunn – GEI) FIELD_STRUCT_DESC: 24-inch corrugated metal drainage pipe through the levee, 5.5 feet below the crown. Concrete U-shaped headwall on both ends. Flap gate on the waterside (WS) end. Cobble grouted spillway. Cobble grouted intake on the landside (LS). [Additional Reference(s): DWR Levee Log, 1978. USACE San Joaquin O&M Manual 612.2, 1967, (HLM 0.86)]. FS Date: 4/29/2021

Levee crown looking downstream.

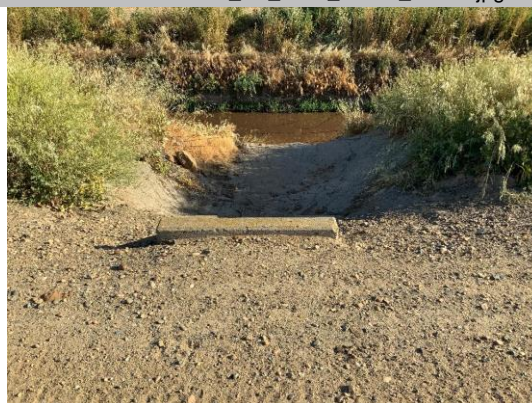
Photo 2 of 3 : UCIP_FA_2021_66864_97265.jpg

LS view: Headwall visible at toe from crown.

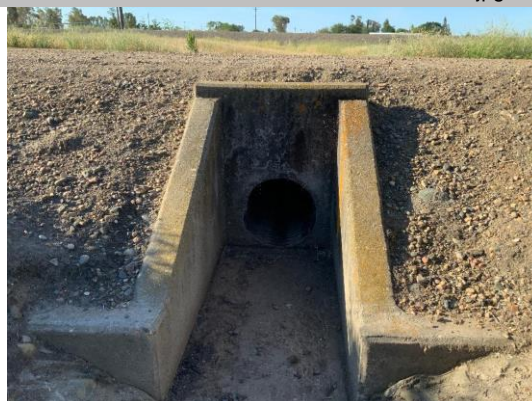
Photo 3 of 3 : UCIP_FA_2021_66864_97266.jpg

LS view: Slope and headwall at toe.

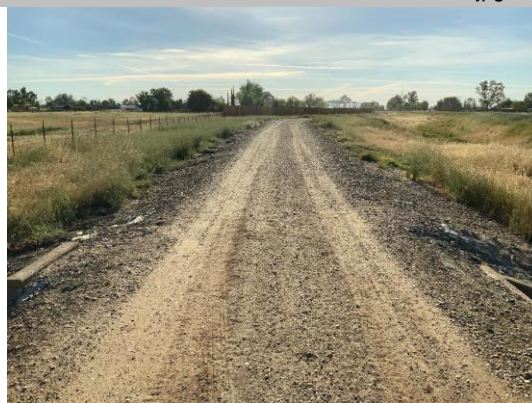
Photo 1 of 3 : UCIP_FA_2021_66865_97270.jpg

DS_ID:23866
 FS_ID:66865
 EP_NO: N/A
 Repair Type: Non-Urgent
 EVAL Issue: Unauthorized Encroachment, installed decades prior
 Crossing Status: Found
 UCIP Comments: 04/29/2021 The record has been upgraded from No Action Needed to Non-Urgent. DWR DMP internal inspection has not found pipe integrity issues. LOF of crossing is less or equal to 4.0. Recommend inspection in 5 years. No permit was found authorizing this encroachment. CVFPB will need to review crossing to determine owner. The UCIP inspection was completed with LMA representative, J. Nelson. (H. Dunn – GEI)
 FIELD_STRUCT_DESC: 24-inch corrugated metal drainage pipe through the levee, 5 feet below the crown. Concrete U-shaped headwall on both ends. Flap gate on the waterside (WS) end. Cobble grouted spillway. Cobble grouted intake on the landside (LS). [Additional Reference(s): DWR Levee Log, 1978. USACE San Joaquin O&M Manual 612.2, 1967, (HLM 1.09)].

Levee crown looking upstream.

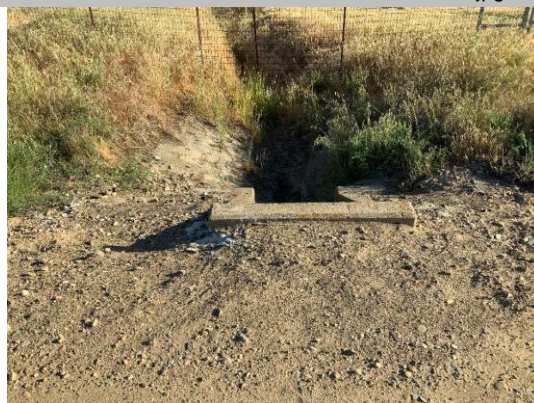
Photo 2 of 3 : UCIP_FA_2021_66865_97271.jpg

LS view: Headwall visible at toe from crown.

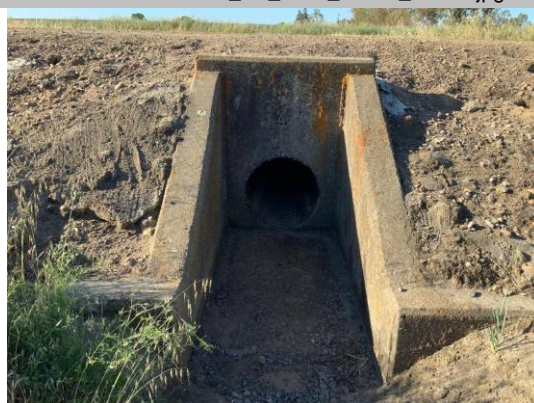
Photo 3 of 3 : UCIP_FA_2021_66865_97272.jpg

LS view: Slope and headwall at toe.

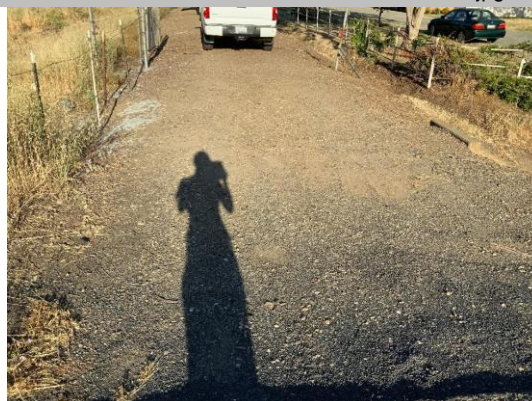
Photo 1 of 3 : UCIP_FA_2021_66866_97278.jpg

Comment Code						
Inspector Comment						
DS_ID:23867 FS_ID:66866 EP_NO: N/A Repair Type: Non-Urgent EVAL Issue: Unauthorized Encroachment, installed decades prior Crossing Status: Found UCIP Comments: 04/29/2021 The record has been upgraded from No Action Needed to Non-Urgent. DWR DMP internal inspection has not found pipe integrity issues. LOF of crossing is less or equal to 4.0. Recommend inspection in 5 years. No permit was found authorizing this encroachment. CVFPB will need to review crossing to determine owner. The UCIP inspection was completed with LMA representative, J. Nelson. (H. Dunn – GEI) FIELD_STRUCT_DESC: 24-inch corrugated metal drainage pipe through the levee, 4 feet below the crown. Concrete U-shaped headwall on both ends. Flap gate on the waterside (WS) end. Cobble grouted spillway. Cobble grouted intake on the landside (LS). [Additional Reference(s): DWR Levee Log, 1978. USACE San Joaquin O&M Manual 612.2, 1967, (HLM 1.33)]. FS Date: 4/29/2021

Levee crown looking downstream.

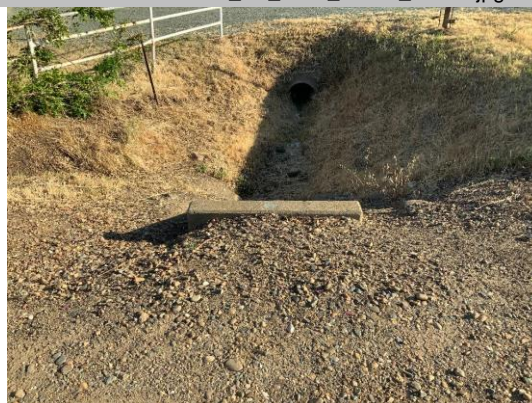
Photo 2 of 3 : UCIP_FA_2021_66866_97279.jpg

LS view: Headwall visible at toe from crown.

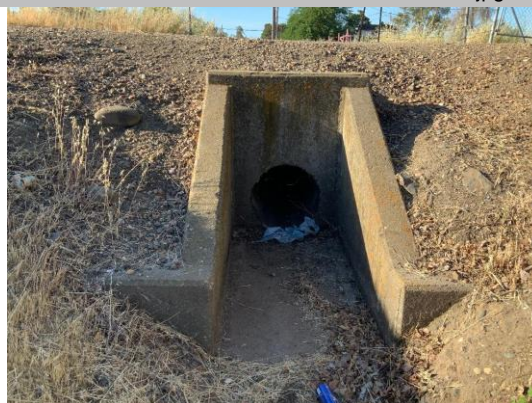
Photo 3 of 3 : UCIP_FA_2021_66866_97280.jpg

LS view: Slope and headwall at toe.

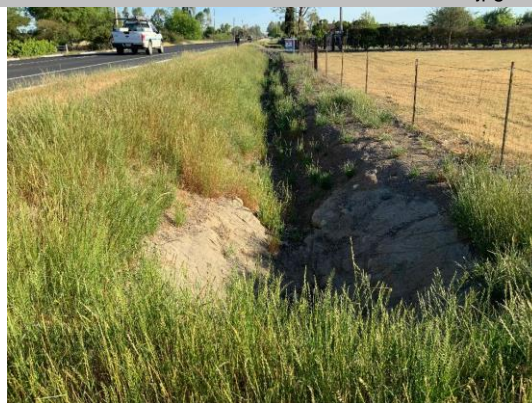
Photo 2 of 3 : UCIP_FA_2021_66867_97286.jpg

DS_ID:23868
 FS_ID:66867
 EP_NO: N/A
 Repair Type: Urgent
 EVAL Issue: Pipe Integrity
 Crossing Status: Found
 UCIP Comments: 04/29/2021 Record has been upgraded from No Action Needed to Urgent. DWR DMP internal inspection has found pipe integrity issues. LOF of crossing is between 5 and 6. Crossing will be monitored until funding becomes available to address the issues. No permit was found authorizing this encroachment. CVFPB will need to review crossing to determine owner. The UCIP inspection was completed with LMA representative, J. Nelson. (H. Dunn ? GEI)04/28/2017 Crossing has been downgraded from Non-Urgent to No Action Needed, since sediment buildup is only minimal. (K. Fazel - UCIP)06/19/2014 Some sediment buildup in pipe at LS toe. (G. Wylie - FPIIB)
 FIELD_STRUCT_DESC: 30-inch corrugated metal drainage pipe through the levee, 6 feet below the crown. Flap gate on the waterside (WS) end. Cobble grouted spillway. Cobble grouted intake on the landside (LS). [Additional Reference(s): DWR Levee Log, 1978. USACE San Joaquin O&M Manual 612.2, 1967, (HLM 1.35)].

LS view: Slope from crown.

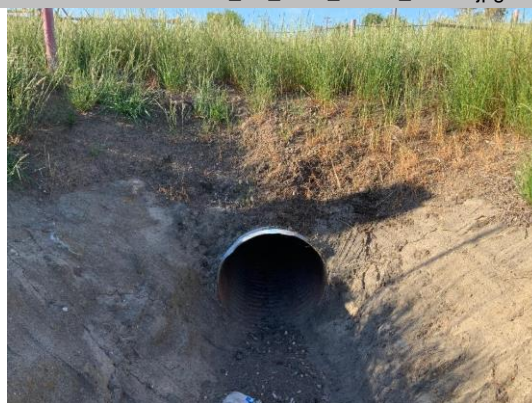
Photo 3 of 3 : UCIP_FA_2021_66867_97287.jpg

LS view: Slope and pipe inlet at toe.

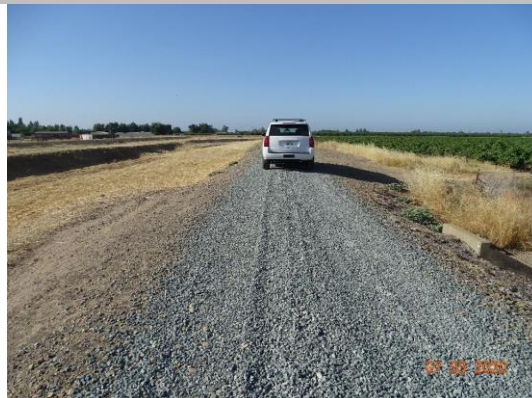
Photo 1 of 3 : UCIP_FA_2021_59640_86887.jpg

Comment Code						
Inspector Comment						
DS_ID:23880 FS_ID:59640 EP_NO: N/A Repair Type: Non-Urgent EVAL Issue: Unauthorized Encroachment, installed decades prior Crossing Status: Found UCIP Comments: 07/03/2020 Crossing evaluated as "Non-Urgent" because there was no permit found authorizing this pipe. (A. McDonald - DWR UCIP) FIELD_STRUCT_DESC: 24-inch corrugated metal drainage pipe through the levee, 5 feet below the crown. Concrete U-shaped headwall on both ends. Flap gate on the waterside (WS) end. Cobble grouted spillway. Cobble grouted intake on the landside (LS). [Additional Reference(s): DWR Levee Log, 1978. USACE San Joaquin O&M Manual 612.2, 1967, (HLM 0.16)]. FS Date: 7/3/2020

Overview of levee crown looking d/s.

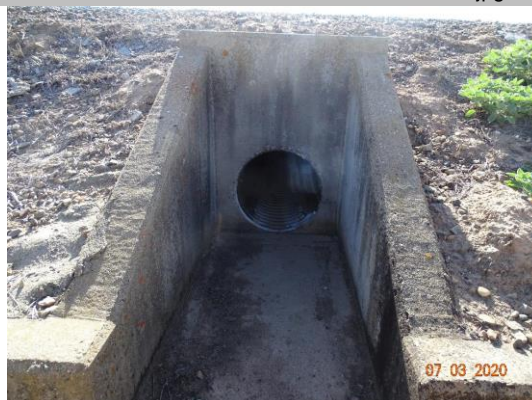
Photo 2 of 3 : UCIP_FA_2021_59640_86888.jpg

Pipe inlet and headwall at LS levee toe.

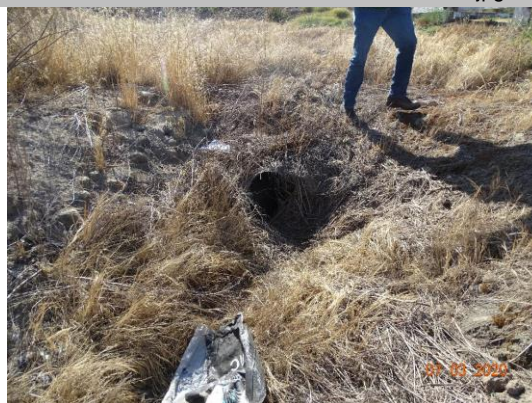
Photo 2 of 3 : UCIP_FA_2021_59641_86894.jpg

DS_ID:23881
FS_ID:59641
EP_NO: N/A
Repair Type: Non-Urgent
EVAL Issue:
Crossing Status: Found
UCIP Comments: 07/03/2020 Crossing evaluated as "Non-Urgent" because there was no permit found authorizing this pipe. (A. McDonald - DWR UCIP) Slide gate does not function properly up or down.
FIELD_STRUCT_DESC: 24-inch corrugated metal drainage pipe through the levee, 11 feet below the crown. Slide gate in 36-inch corrugated metal riser unit on the waterside (WS). Concrete U-shaped headwall on the WS end. Cobble grouted spillway. Cobble grouted intake on the landside (LS). [Additional Reference(s): DWR Levee Log, 1978. USACE San Joaquin O&M Manual 612.2, 1967, (HLM 0.47)].
FS Date: 7/3/2020

Pipe inlet at the LS levee toe. No headwall.

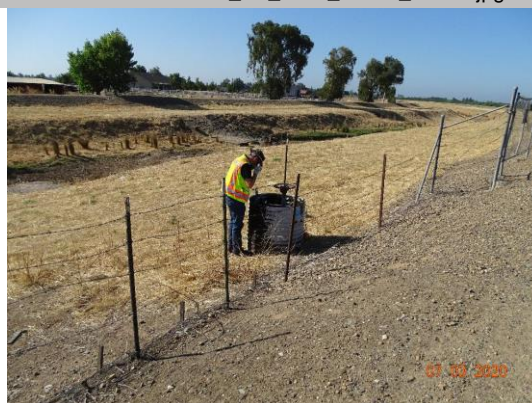
Photo 3 of 3 : UCIP_FA_2021_59641_86895.jpg

Riser and slide gate at the WS levee toe.

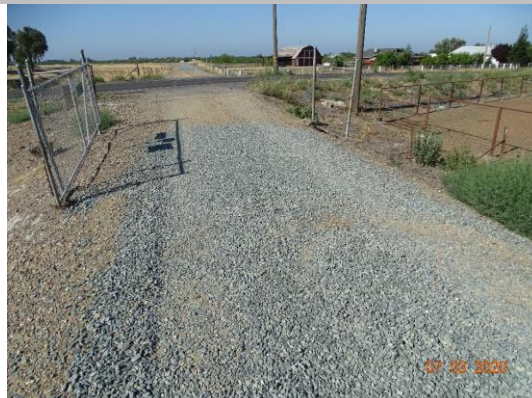
Photo 1 of 3 : UCIP_FA_2021_59642_86906.jpg

Comment Code						
Inspector Comment						
DS_ID:23882 FS_ID:59642 EP_NO: N/A Repair Type: Non-Urgent EVAL Issue: Unauthorized Encroachment, installed decades prior Crossing Status: Found UCIP Comments: 07/03/2020 Crossing evaluated as "Non-Urgent" because there was no permit found authorizing this pipe. Video inspection performed on 02/21/2020. (A. McDonald - DWR UCIP) FIELD_STRUCT_DESC: 24-inch corrugated metal drainage pipe through the levee, 7 feet below the crown. Concrete U-shaped headwall on both ends. Flap gate on the waterside (WS) end. Cobble grouted spillway. Cobble grouted intake on the landside (LS). [Additional Reference(s): DWR Levee Log, 1978. USACE San Joaquin O&M Manual 612.2, 1967, (HLM 0.50)]. FS Date: 7/3/2020

Overview of levee crown looking d/s.

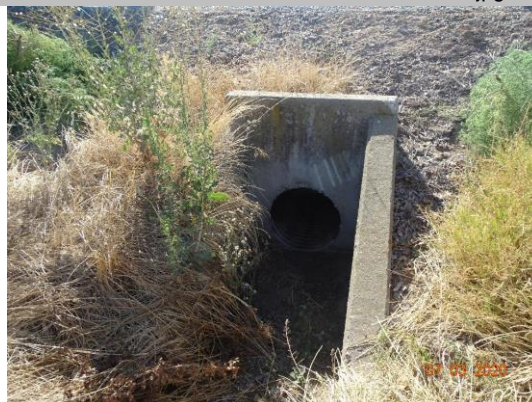
Photo 2 of 3 : UCIP_FA_2021_59642_86907.jpg

Pipe inlet and headwall at the LS levee toe.

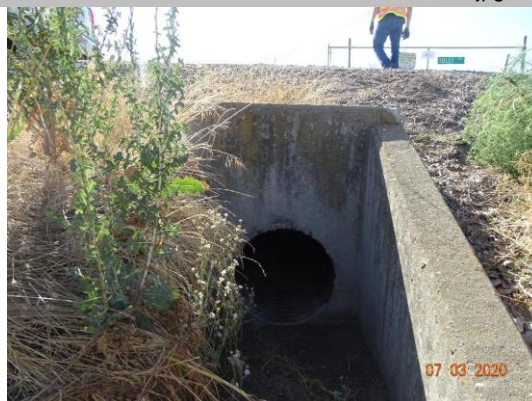
Photo 3 of 3 : UCIP_FA_2021_59642_86908.jpg

Pipe inlet and headwall at the LS levee toe.

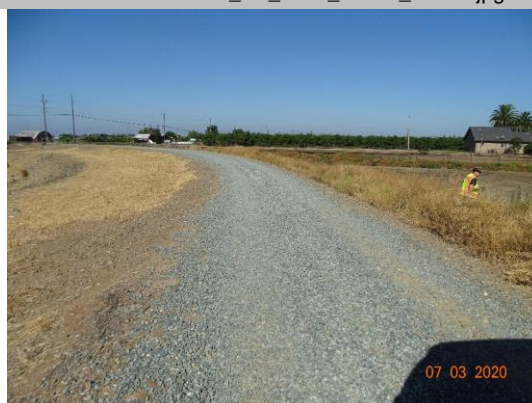
Photo 1 of 3 : UCIP_FA_2021_59643_86911.jpg

DS_ID:23883
 FS_ID:59643
 EP_NO: N/A
 Repair Type: Non-Urgent
 EVAL Issue: Unauthorized Encroachment, installed decades prior
 Crossing Status: Found
 UCIP Comments: 07/03/2020 Crossing evaluated as "Non-Urgent" because there was no permit found authorizing this pipe. Video inspection performed on 02-21-2020. (A. McDonald - DWR UCIP) Pipe filled in with soil on the LS toe and appears to be temporarily abandoned.
 FIELD_STRUCT_DESC: 24-inch corrugated metal drainage pipe through the levee, 6.5 feet below the crown. Concrete U-shaped headwall on both ends. Flap gate on the waterside (WS) end. Cobble grouted spillway. Cobble grouted intake on the landside (LS).
 [Additional Reference(s): DWR Levee Log, 1978. USACE San Joaquin O&M Manual 612.2, 1967, (HLM 0.55)].
 FS Date: 7/3/2020

Overview of levee crown looking d/s.
