**Flood Control Project Maintenance
Levee Inspections**

Maintenance Issue Types Only, Levee Inspection Report By Mile - Fall 2021

San Joaquin County Flood Control and Water Conservation District

Waterway	Bank	Unit Miles	Inspection Start/End	Inspector
Unit No. 01 Littlejohn Creek	Left	2.59	10/21/2021 10/21/2021	Alberto De Leon

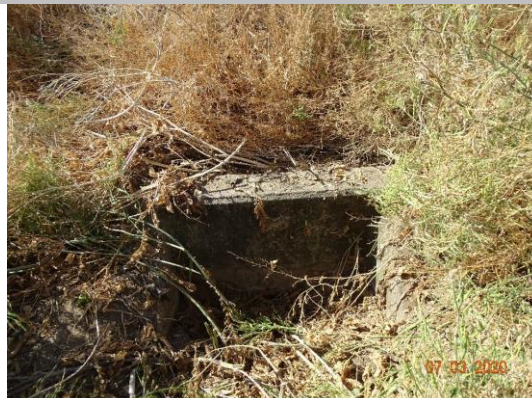
Photo 2 of 3 : UCIP_FA_2021_59643_86912.jpg

DS_ID:23883
 FS_ID:59643
 EP_NO: N/A
 Repair Type: Non-Urgent
 EVAL Issue: Unauthorized Encroachment, installed decades prior
 Crossing Status: Found
 UCIP Comments: 07/03/2020 Crossing evaluated as "Non-Urgent" because there was no permit found authorizing this pipe. Video inspection performed on 02-21-2020. (A. McDonald - DWR UCIP) Pipe filled in with soil on the LS toe and appears to be temporarily abandoned.
 FIELD_STRUCT_DESC: 24-inch corrugated metal drainage pipe through the levee, 6.5 feet below the crown. Concrete U-shaped headwall on both ends. Flap gate on the waterside (WS) end. Cobble grouted spillway. Cobble grouted intake on the landside (LS).
 [Additional Reference(s): DWR Levee Log, 1978. USACE San Joaquin O&M Manual 612.2, 1967, (HLM 0.55)].
 FS Date: 7/3/2020

Pipe inlet and headwall at the LS levee toe.

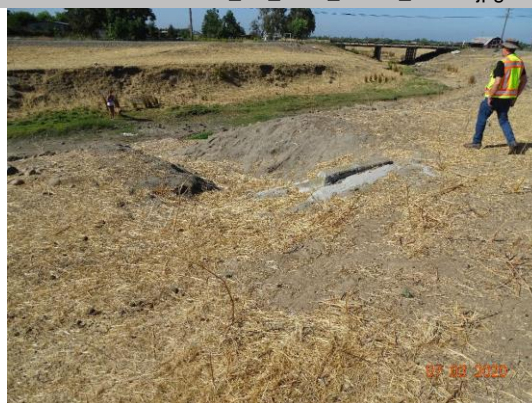
Photo 3 of 3 : UCIP_FA_2021_59643_86913.jpg

Pipe outlet, headwall, and flap gate at the WS levee toe.

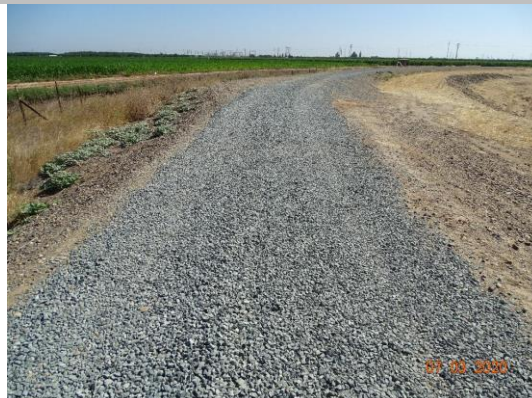
Photo 1 of 3 : UCIP_FA_2021_59645_86934.jpg

Comment Code						
Inspector Comment						
DS_ID:23885 FS_ID:59645 EP_NO: N/A Repair Type: Non-Urgent EVAL Issue: Unauthorized Encroachment, installed decades prior Crossing Status: Found UCIP Comments: 07/03/2020 Crossing evaluated as "Non-Urgent" because there was no permit found authorizing this pipe. Video inspection performed on 04-24-2020. (A. McDonald - DWR UCIP) FIELD_STRUCT_DESC: 24-inch corrugated metal drainage pipe through the levee, 6 feet below the crown. Concrete U-shaped headwall on both ends. Flap gate on the waterside (WS) end. Slide gate on the landside (LS) end. Cobble grouted spillway. Cobble grouted intake on the LS. [Additional Reference(s): DWR Levee Log, 1978. USACE San Joaquin O&M Manual 612.2, 1967, (HLM 1.07)]. FS Date: 7/3/2020

Overview of levee crown looking d/s.

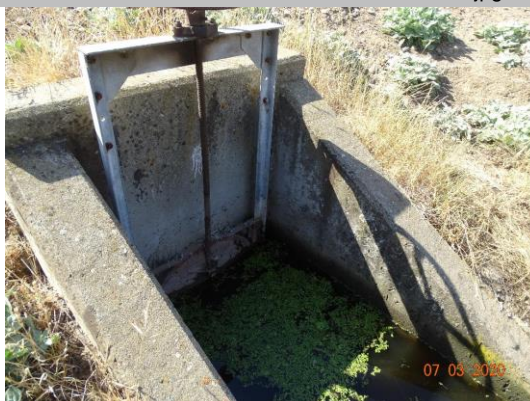
Photo 3 of 3 : UCIP_FA_2021_59645_86931.jpg

Pipe inlet, headwall, and slide gate at the LS levee toe.

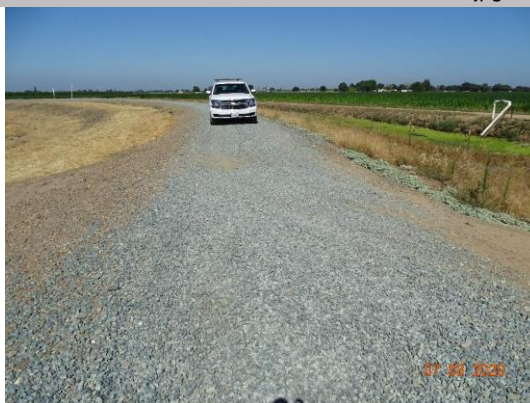
Photo 1 of 3 : UCIP_FA_2021_59646_86936.jpg

DS_ID:23870
 FS_ID:59646
 EP_NO: N/A
 Repair Type: Non-Urgent
 EVAL Issue: Unauthorized Encroachment, installed decades prior
 Crossing Status: Found
 UCIP Comments: 07/03/2020 Crossing evaluated as "Non-Urgent" because there was no permit found authorizing this pipe. (A. McDonald - DWR UCIP)
 FIELD_STRUCT_DESC: 24-inch corrugated metal drainage pipe through the levee, 8 feet below the crown. Concrete U-shaped headwall on both ends. Flap gate on the waterside (WS) end. Slide gate on the landside (LS) end. Two corrugated metal cutoff walls. Cobble grouted spillway. Cobble grouted intake on the LS. [Additional Reference(s): DWR Levee Log, 1978. USACE San Joaquin O&M Manual 612.2, 1967, (HLM 1.15)].
 FS Date: 7/3/2020

Overview of levee crown looking d/s.

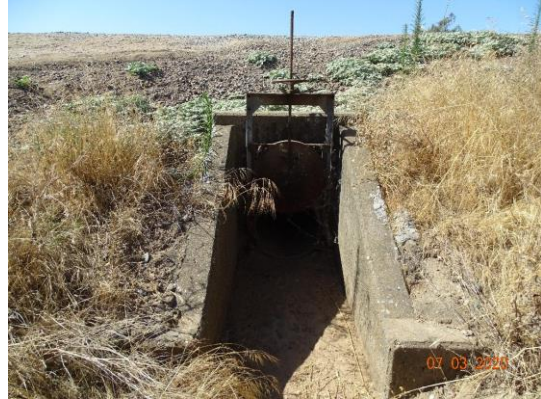
Photo 2 of 3 : UCIP_FA_2021_59646_86937.jpg

Pipe inlet, headwall, and slide gate at the LS levee toe.

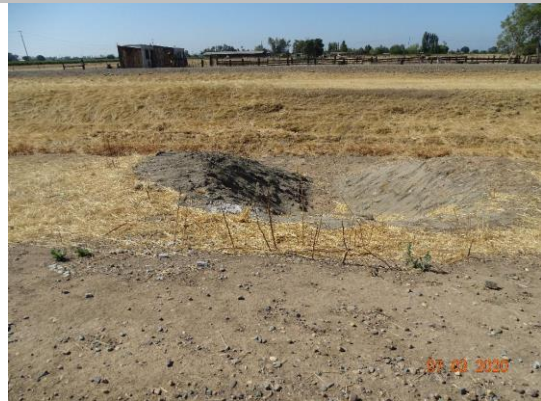
Photo 3 of 3 : UCIP_FA_2021_59646_86938.jpg

View of WS channel looking from the levee crown.

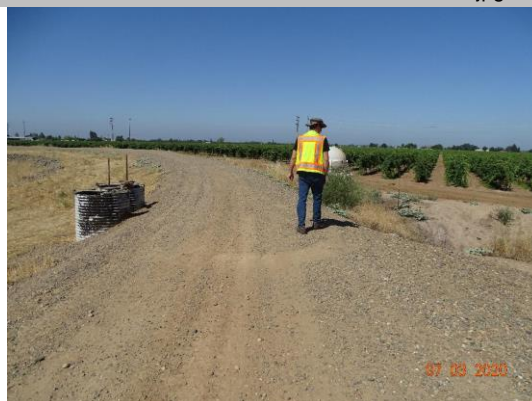
Photo 1 of 3 : UCIP_FA_2021_59647_86960.jpg

Comment Code						
Inspector Comment						
DS_ID:23871 FS_ID:59647 EP_NO: N/A Repair Type: Non-Urgent EVAL Issue: Unauthorized Encroachment, installed decades prior Crossing Status: Found UCIP Comments: 07/03/2020 Crossing evaluated as "Non-Urgent" because there was no permit found authorizing this pipe. (A. McDonald - DWR UCIP) Slide gate may be rusted shut or does not function. Heavy sediment buildup in pipe. Lid on CMP riser needs repair. FIELD_STRUCT_DESC: 1 of 2: 36-inch corrugated metal drainage pipe through the levee, 7 feet below the crown. Slide gate in 48-inch corrugated metal riser unit on the waterside (WS) slope. Concrete U-shaped headwall on both ends. Flap gate on the WS end. Cobble grouted spillway. Cobble grouted intake on the landside (LS). [Additional Reference(s): DWR Levee Log, 1978. USACE San Joaquin O&M Manual 612.2, 1967, (HLM 1.51)]. FS Date: 7/3/2020

Overview of levee crown looking d/s.

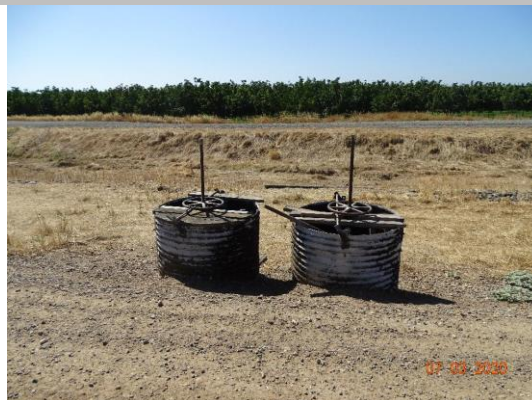
Photo 3 of 3 : UCIP_FA_2021_59648_86967.jpg

Two risers and slide gates on the WS levee slope.

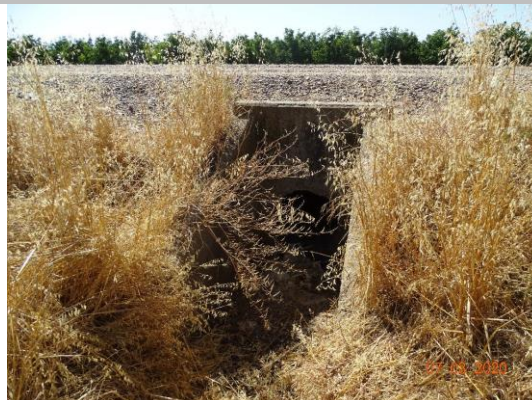
Photo 2 of 3 : UCIP_FA_2021_59649_86979.jpg

Comment Code					
Inspector Comment					
DS_ID:23872					
FS_ID:59649					
EP_NO: N/A					
Repair Type: Non-Urgent					
EVAL Issue: Unauthorized Encroachment, installed decades prior					
Crossing Status: Found					
UCIP Comments: 07/03/2020 Crossing evaluated as "Non-Urgent"					
because there was no permit found authorizing this pipe. (A.					
McDonald - DWR UCIP)					
FIELD_STRUCT_DESC: 24-inch corrugated metal drainage pipe					
through the levee, 5.5 feet below the crown. Concrete U-shaped					
headwall on both ends. Flap gate on the waterside (WS) end. Cobble					
grouted spillway. Cobble grouted intake on the landside (LS).					
[Additional Reference(s): DWR Levee Log, 1978. USACE San Joaquin					
O&M Manual 612.2, 1967, (HLM 1.82)].					
FS Date: 7/3/2020

Pipe inlet and headwall located at the LS levee toe.

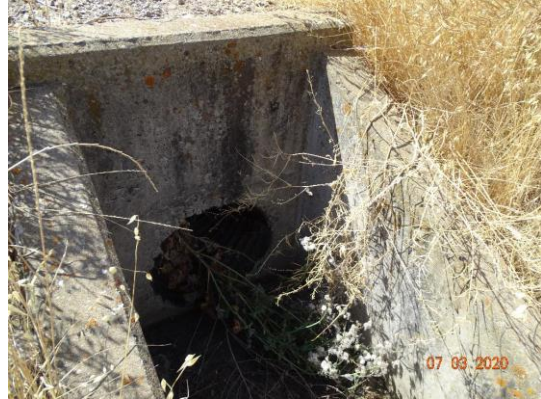
Photo 2 of 3 : UCIP_FA_2021_59651_86989.jpg

Inlet pipe and headwall located at the LS levee toe.

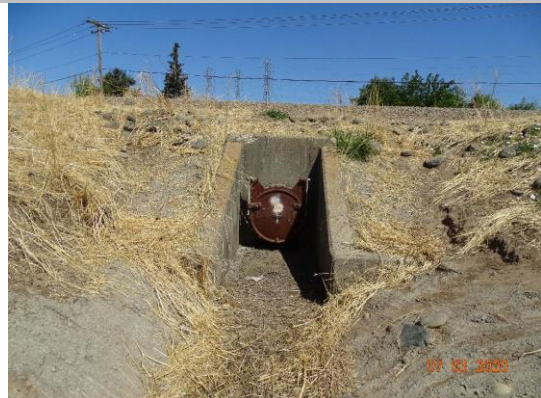
Photo 3 of 3 : UCIP_FA_2021_59651_86990.jpg

Outlet pipe, flap gate, and headwall located at the WS levee toe.

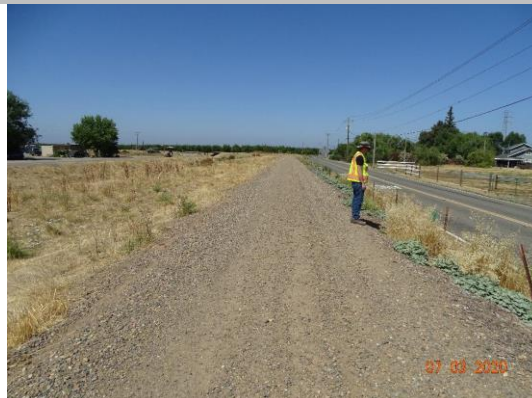
Photo 1 of 3 : UCIP_FA_2021_59652_86991.jpg

Comment Code						
Inspector Comment						
DS_ID:23875 FS_ID:59652 EP_NO: N/A Repair Type: Non-Urgent EVAL Issue: Unauthorized Encroachment, installed decades prior Crossing Status: Found UCIP Comments: 07/03/2020 Crossing evaluated as "Non-Urgent" because there was no permit found authorizing this pipe. Video inspection performed on 04-22-2020. (A. McDonald - DWR UCIP) FIELD_STRUCT_DESC: 12-inch corrugated metal drainage pipe through the levee, 5.5 feet below the crown. Flap gate on the waterside (WS) end. Drop inlet with grate at the landside (LS) toe. Spillway cobble grouted. [Additional Reference(s): DWR Levee Log, 1978. USACE San Joaquin O&M Manual 612.2, 1967, (HLM 2.14)]. FS Date: 7/3/2020

Overview of levee crown looking d/s.

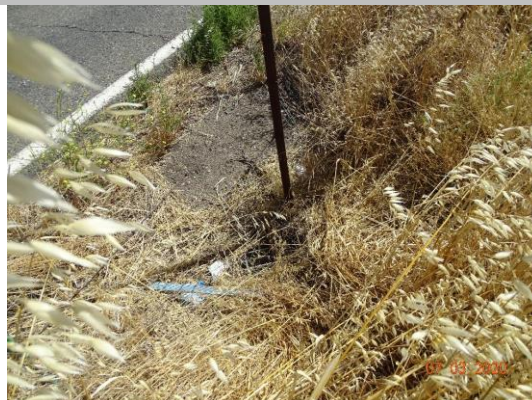
Photo 2 of 3 : UCIP_FA_2021_59652_86992.jpg

View of pipe inlet at the LS levee toe.

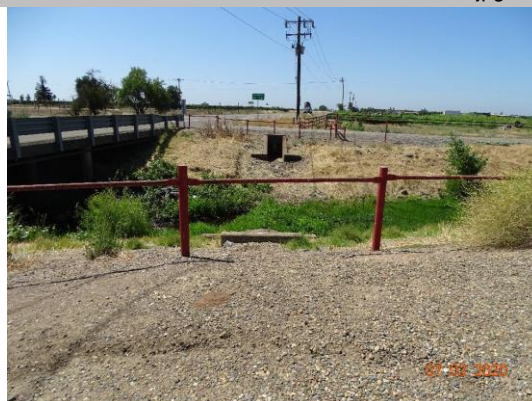
Photo 2 of 3 : UCIP_FA_2021_59653_86997.jpg

View of channel on WS and opposite levee.

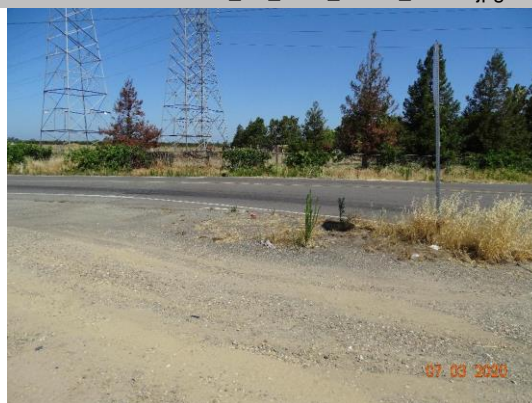
Photo 3 of 3 : UCIP_FA_2021_59653_86998.jpg

View of LS and pipe inlet.

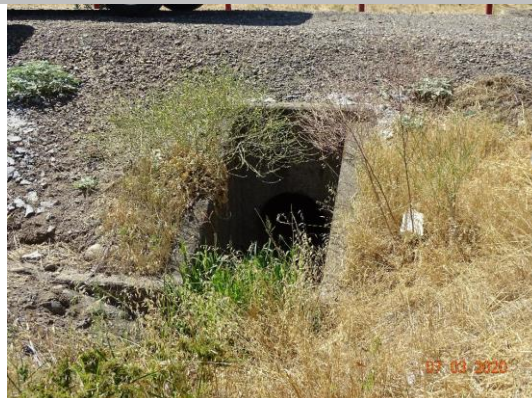
Photo 1 of 3 : UCIP_FA_2021_59656_87021.jpg

Comment Code						
Inspector Comment						
DS_ID:23878 FS_ID:59656 EP_NO: N/A Repair Type: Non-Urgent EVAL Issue: Unauthorized Encroachment, installed decades prior Crossing Status: Found UCIP Comments: 07/03/2020 Crossing evaluated as "Non-Urgent" because there was no permit found authorizing this pipe. (A. McDonald - DWR UCIP) FIELD_STRUCT_DESC: 24-inch corrugated metal drainage pipe through the levee, 5 feet below the crown. Concrete U-shaped headwall on both ends. Flap gate on the waterside (WS) end. Cobble grouted spillway. Cobble grouted intake on the landside (LS). [Additional Reference(s): DWR Levee Log, 1978. USACE San Joaquin O&M Manual 612.2, 1967, (HLM 2.24)]. FS Date: 7/3/2020

View of pipe inlet and headwall located at the LS levee toe.

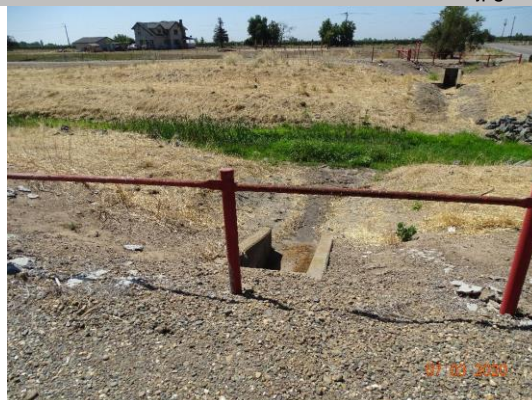
Photo 2 of 3 : UCIP_FA_2021_59656_87022.jpg

View of pipe outlet, WS channel, and opposite levee looking from the levee crown.

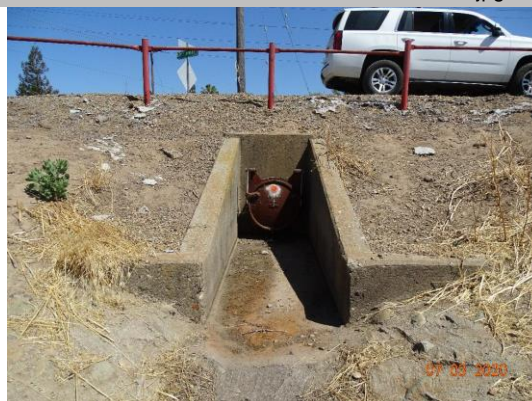
Photo 3 of 3 : UCIP_FA_2021_59656_87023.jpg

View of pipe outlet, flap gate, and headwall located at the WS levee toe.

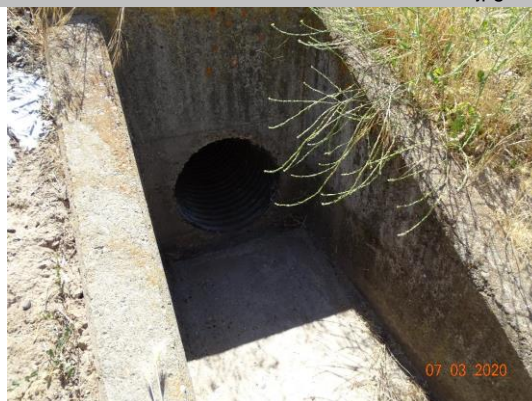
Photo 2 of 3 : UCIP_FA_2021_59659_87031.jpg

View of pipe inlet and headwall located at the LS levee toe.

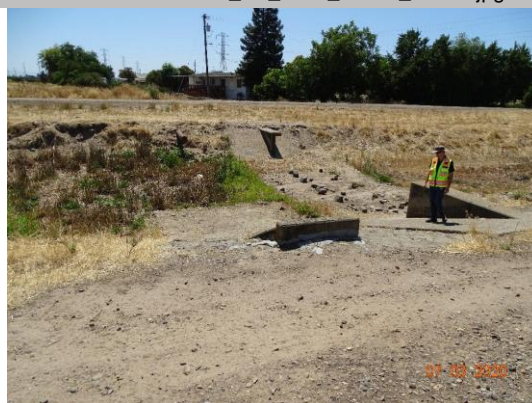
Photo 3 of 3 : UCIP_FA_2021_59659_87032.jpg

View of pipe outlet and channel located on the WS.

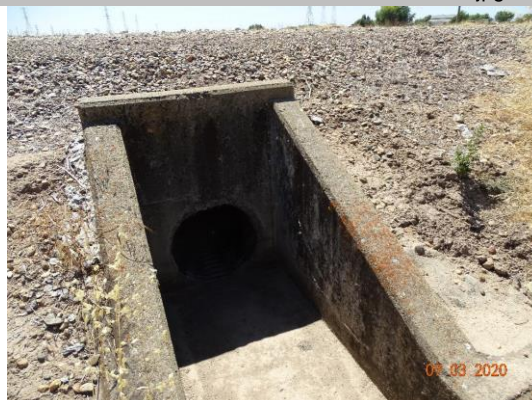
Photo 2 of 3 : UCIP_FA_2021_59660_87035.jpg

Comment Code					
Inspector Comment					
DS_ID:23888 FS_ID:59660 EP_NO: N/A Repair Type: Non-Urgent EVAL Issue: Unauthorized Encroachment, installed decades prior Crossing Status: Found UCIP Comments: 07/03/2020 Crossing evaluated as "Non-Urgent" because there was no permit found authorizing this pipe. Video inspection performed on 04-22-2020. (A. McDonald - DWR UCIP) FIELD_STRUCT_DESC: 24-inch corrugated metal drainage pipe through the levee, 6 feet below the crown. Concrete U-shaped headwall on both ends. Flap gate on the waterside (WS) end. Cobble grouted spillway. Cobble grouted intake on the landside (LS). [Additional Reference(s): DWR Levee Log, 1978. USACE San Joaquin O&M Manual 612.2, 1967, (HLM 2.58)]. FS Date: 7/3/2020

View of pipe inlet and headwall located at the LS levee toe.

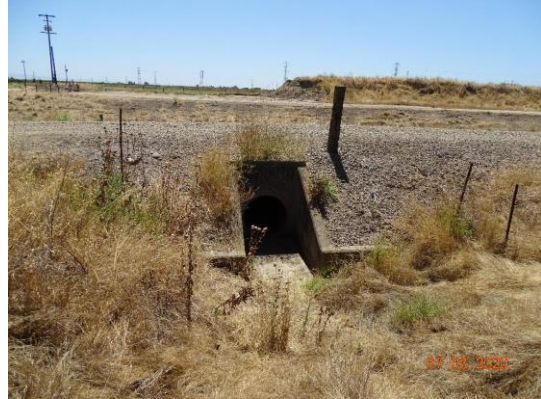
Photo 2 of 3 : UCIP_FA_2021_59670_87046.jpg

View of pipe inlet and headwall located at the LS levee toe.

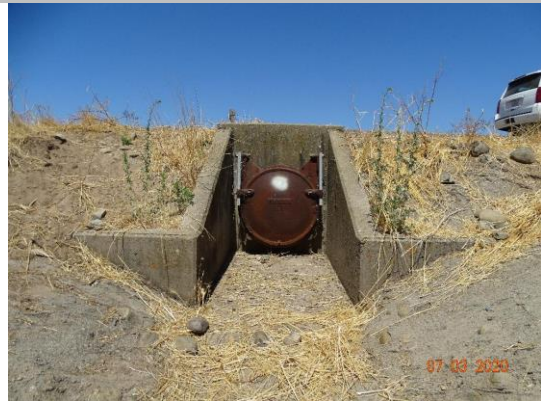
Photo 3 of 3 : UCIP_FA_2021_59670_87047.jpg

View of pipe outlet, flap gate, headwall, and splash apron located at the WS levee toe.

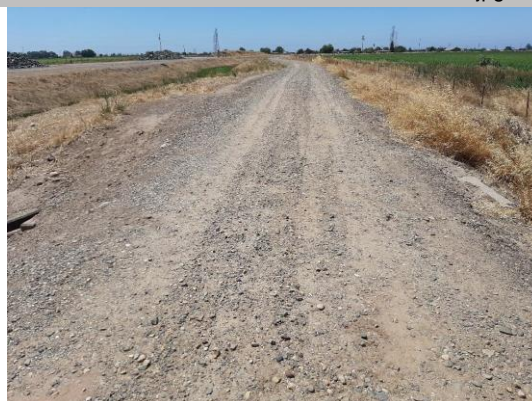
Photo 1 of 3 : UCIP_FA_2021_59663_87048.jpg

Comment Code					
Inspector Comment					
DS_ID:23891 FS_ID:59663 EP_NO: N/A Repair Type: Non-Urgent EVAL Issue: Unauthorized Encroachment, installed decades prior Crossing Status: Found UCIP Comments: 07/03/2020 Crossing evaluated as "Non-Urgent" because there was no permit found authorizing this pipe. Video inspection performed on 04-22-2020. (A. McDonald - DWR UCIP) FIELD_STRUCT_DESC: 24-inch corrugated metal drainage pipe through the levee, 6 feet below the crown. Concrete U-shaped headwall on both ends. Flap gate on the waterside (WS) end. Cobble grouted spillway. Cobble grouted intake on the landside (LS). [Additional Reference(s): DWR Levee Log, 1978. USACE San Joaquin O&M Manual 612.2, 1967, (HLM 2.88)]. FS Date: 7/3/2020

Overview of levee crown looking d/s.

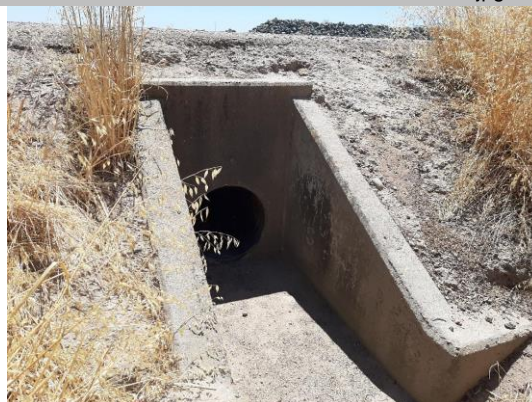
Photo 2 of 3 : UCIP_FA_2021_59663_87049.jpg

View of pipe inlet and headwall located at the LS levee toe.

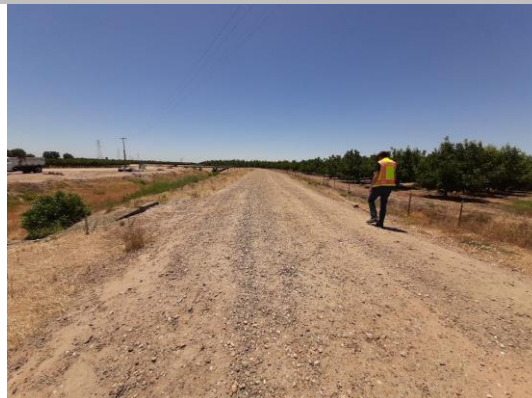
Photo 1 of 3 : UCIP_FA_2021_59668_87065.jpg

Comment Code						
Inspector Comment						
DS_ID:23895 FS_ID:59668 EP_NO: N/A Repair Type: Non-Urgent EVAL Issue: Unauthorized Encroachment, installed decades prior Crossing Status: Found UCIP Comments: 07/03/2020 Crossing evaluated as "Non-Urgent" because there was no permit found authorizing this pipe. (A. McDonald - DWR UCIP) FIELD_STRUCT_DESC: 24-inch corrugated metal drainage pipe through the levee, 5 feet below the crown. Concrete U-shaped headwall on both ends. Flap gate on the waterside (WS) end. Cobble grouted spillway. Cobble grouted intake on the landside (LS). [Additional Reference(s): DWR Levee Log, 1978. USACE San Joaquin O&M Manual 612.2, 1967, (HLM 3.47)]. FS Date: 7/3/2020

Overview of levee crown looking d/s.

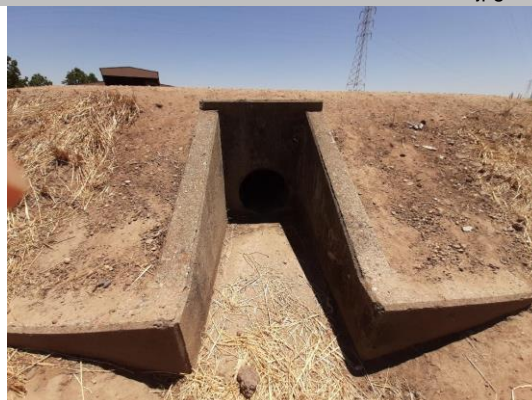
Photo 2 of 3 : UCIP_FA_2021_59668_87066.jpg

View of pipe inlet and headwall located at the LS levee toe.

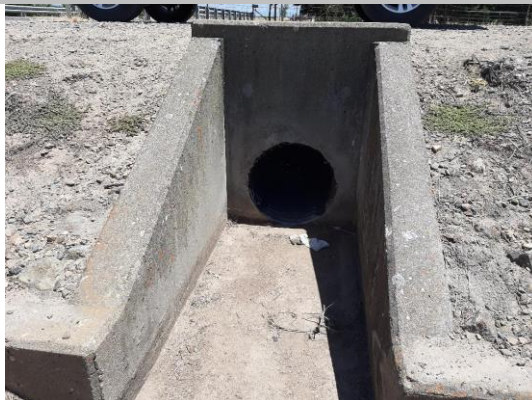
Photo 2 of 3 : UCIP_FA_2021_59669_87069.jpg

View of pipe inlet and headwall located at the LS levee toe.

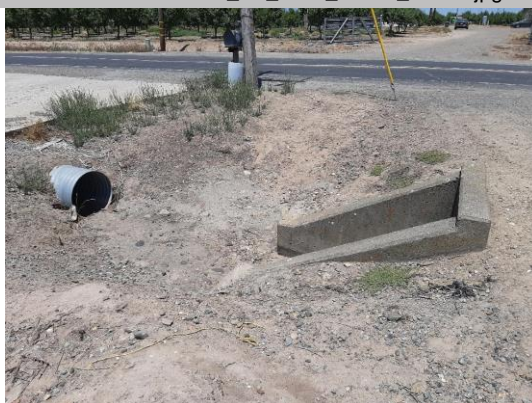
Photo 3 of 3 : UCIP_FA_2021_59669_87070.jpg

Drainage pipe under driveway leading to the inlet at the LS levee toe.

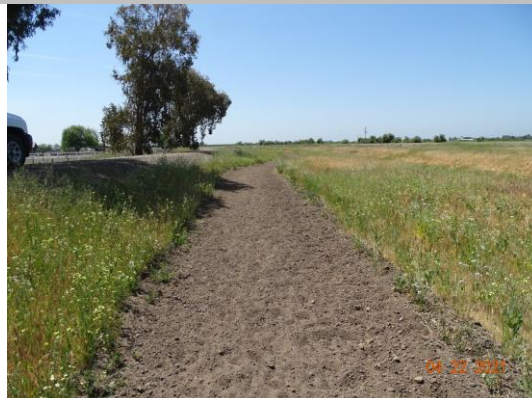
Photo 1 of 1 : FA_2021_NA0017_156_40_20210913_00006.jpg

LM Start	0.06	Rating **	A/W	Issue No.	40
LM End	0.47	Issue Type +	Ma	Location *	WS
Category	Earthen Levee			GPS Latitude/Longitude	
				Start	End
Item	Animal Control			38.095909 °	38.101703 °
				-121.168743 °	-121.167955 °
DWR ID	DWR_NA0017_12_s_2021_40				
Comment Code					
A2 : Repair the levee slope damaged by livestock and prevent large animal access.					
Inspector Comment					
Landowners are using the waterside berm as a horse path.

View horse trail within the waterside berm. Spring 2021

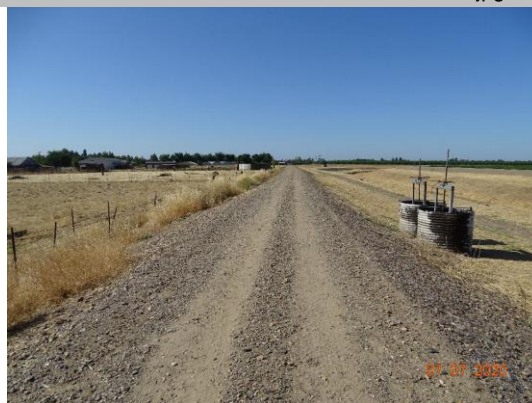
Photo 1 of 3 : UCIP_FA_2021_59601_87072.jpg

Comment Code					
Inspector Comment					
DS_ID:23925 FS_ID:59601 EP_NO: N/A Repair Type: Non-Urgent EVAL Issue: Unauthorized Encroachment, installed decades prior Crossing Status: Found UCIP Comments: 07/07/2020 Crossing evaluated as "Non-Urgent" because there was no permit found authorizing this pipe. Video inspection performed on 05-07-2020. (A. McDonald - DWR UCIP)Gate valve rusted in place. No lid or cover on Standpipe on WS slope. FIELD_STRUCT_DESC: 1 of 2: 42-inch corrugated metal drainage pipe through the levee, 7 feet below the crown. Slide gate in a 56-inch corrugated metal riser unit on the waterside (WS) slope. Flap gate on the WS end. Concrete headwall on both ends. [Additional Reference(s): DWR Levee Log, 1978. USACE San Joaquin O&M Manual 612.2, 1967, (HLM 0.14) 36-inch pipe listed]. FS Date: 7/7/2020

Overview of levee crown looking d/s.

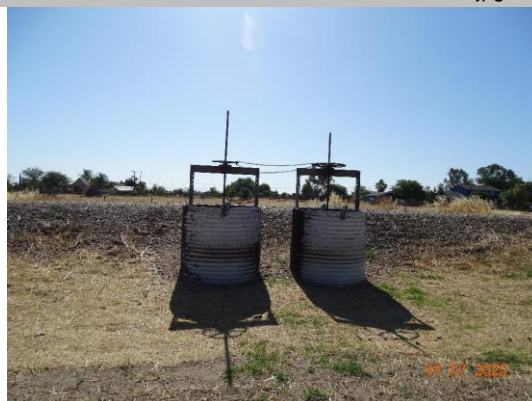
Photo 2 of 3 : UCIP_FA_2021_59601_87073.jpg

Two risers with gate valves located on the WS levee slope.

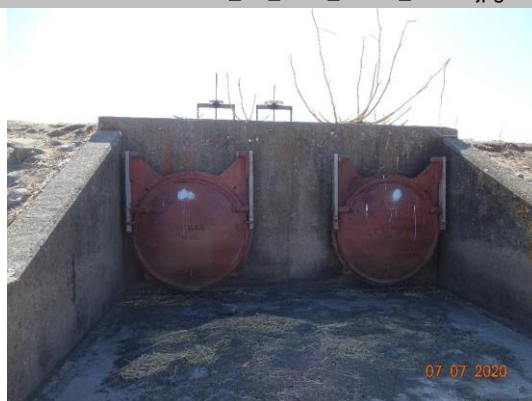
Photo 3 of 3 : UCIP_FA_2021_59601_87074.jpg

Two pipe outlets, flap gates, and headwall located on the WS berm.

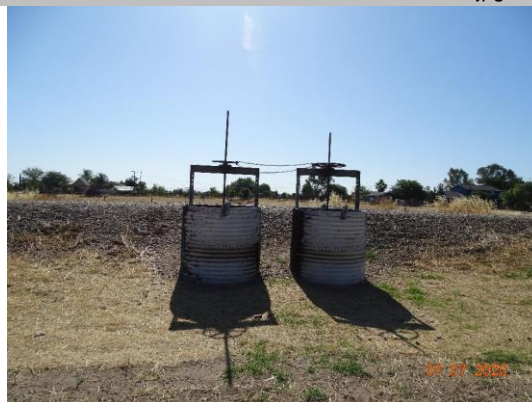
Photo 2 of 3 : UCIP_FA_2021_59602_87077.jpg

Two risers and gate valves located on the WS levee slope.

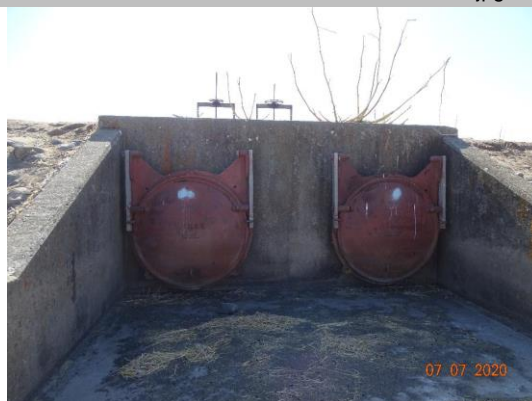
Photo 3 of 3 : UCIP_FA_2021_59602_87078.jpg

Two pipe outlets, flap gates, and headwall located on the WS berm.

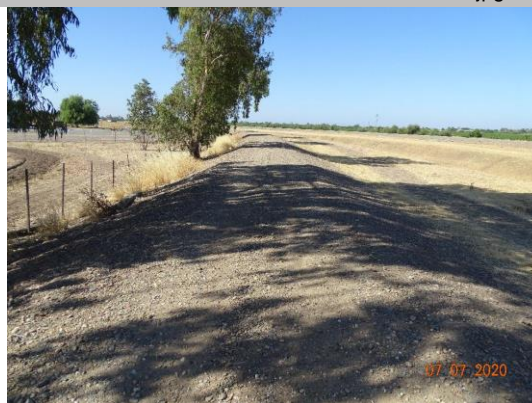
Photo 1 of 3 : UCIP_FA_2021_59603_87080.jpg

DS_ID:23900
 FS_ID:59603
 EP_NO: N/A
 Repair Type: Non-Urgent
 EVAL Issue: Unauthorized Encroachment, installed decades prior
 Crossing Status: Found
 UCIP Comments: 07/07/2020 Crossing evaluated as "Non-Urgent" because there was no permit found authorizing this pipe. (A. McDonald - DWR UCIP)
 FIELD_STRUCT_DESC: 24-inch corrugated metal drainage pipe through the levee, 6.5 feet below the crown. Concrete U-shaped headwall on both ends. Flap gate on the waterside (WS) end. Cobble grouted spillway. Cobble grouted intake on the landside (LS).
 [Additional Reference(s): DWR Levee Log, 1978. USACE San Joaquin O&M Manual 612.2, 1967, (HLM 0.40)].
 FS Date: 7/7/2020

Overview of levee crown looking d/s.

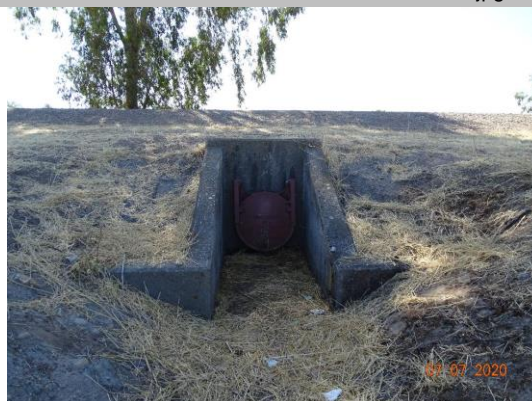
Photo 2 of 3 : UCIP_FA_2021_59603_87081.jpg

View of pipe outlet, flap gate, and headwall located on the WS berm.

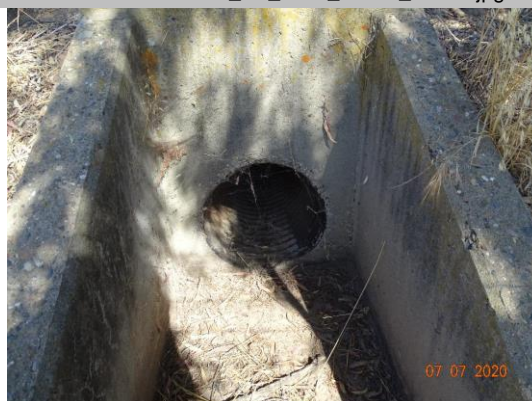
Photo 3 of 3 : UCIP_FA_2021_59603_87082.jpg

View of pipe inlet and headwall located at the LS levee toe.

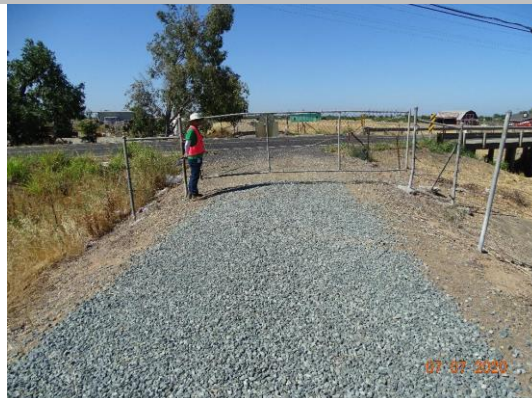
Photo 1 of 3 : UCIP_FA_2021_59605_87089.jpg

Comment Code						
Inspector Comment						
DS_ID:23901 FS_ID:59605 EP_NO: N/A Repair Type: Non-Urgent EVAL Issue: Unauthorized Encroachment, installed decades prior Crossing Status: Found UCIP Comments: 07/07/2020 Crossing evaluated as "Non-Urgent" because there was no permit found authorizing this pipe. (A. McDonald - DWR UCIP) FIELD_STRUCT_DESC: 24-inch corrugated metal drainage pipe through the levee, 7 feet below the crown. Concrete U-shaped headwall on both ends. Flap gate on the waterside (WS) end. Cobble grouted spillway. Cobble grouted intake on the landside (LS) end. [Additional Reference(s): DWR Levee Log, 1978. USACE San Joaquin O&M Manual 612.2, 1967, (HLM 0.48)]. FS Date: 7/7/2020

Overview of levee crown looking d/s.

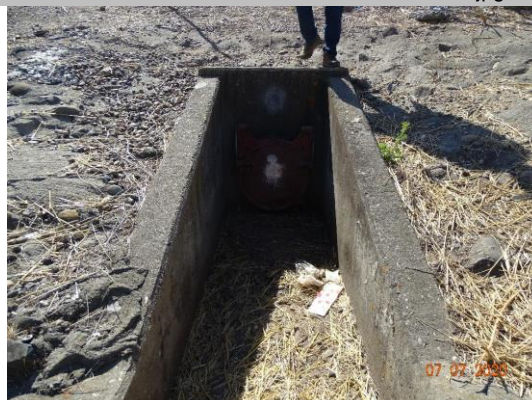
Photo 2 of 3 : UCIP_FA_2021_59605_87090.jpg

View of pipe outlet, flap gate, and headwall located at the WS levee toe.

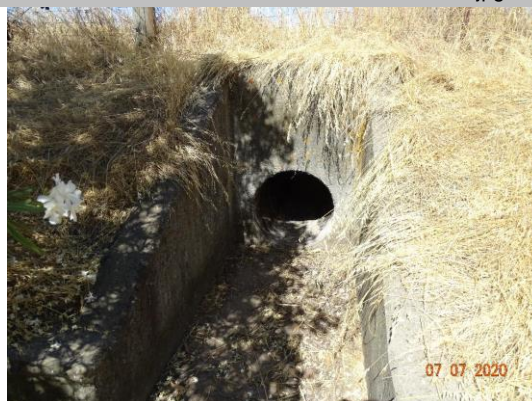
Photo 3 of 3 : UCIP_FA_2021_59607_87097.jpg

View of pipe inlet and headwall located at the LS levee toe.

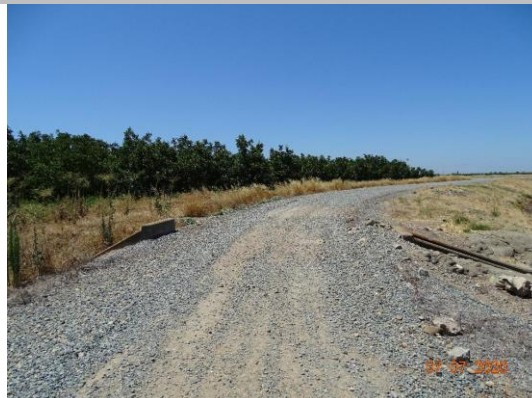
Photo 1 of 3 : UCIP_FA_2021_59608_87098.jpg

Comment Code						
Inspector Comment						
DS_ID:23904 FS_ID:59608 EP_NO: N/A Repair Type: Non-Urgent EVAL Issue: Unauthorized Encroachment, installed decades prior Crossing Status: Found UCIP Comments: 07/07/2020 Crossing evaluated as "Non-Urgent" because there was no permit found authorizing this pipe. (A. McDonald - DWR UCIP) FIELD_STRUCT_DESC: 24-inch corrugated metal drainage pipe through the levee, 2 feet below the crown. Concrete U-shaped headwalls on both ends. Flap gate on the waterside (WS) end. Cobble grouted spillway. Cobble grouted intake on the landside (LS). [Additional Reference(s): DWR Levee Log, 1978. USACE San Joaquin O&M Manual 612.2, 1967, (HLM 1.51)]. FS Date: 7/7/2020

Overview of levee crown looking d/s.

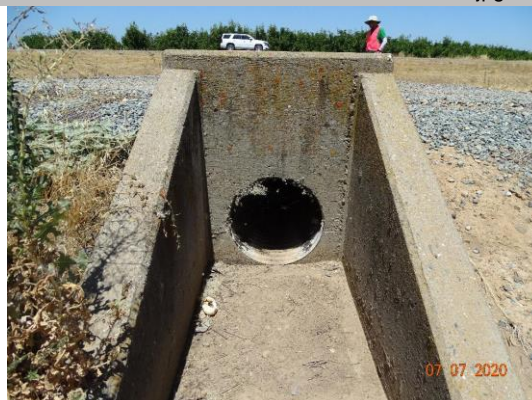
Photo 2 of 3 : UCIP_FA_2021_59608_87099.jpg

View of pipe inlet and headwall located at the LS levee toe.

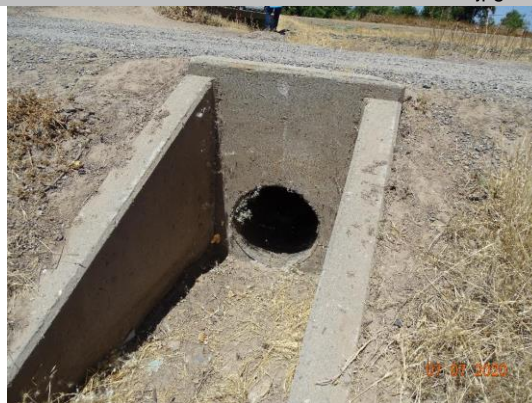
Photo 2 of 3 : UCIP_FA_2021_59610_87105.jpg

View of pipe inlet and headwall located at the LS levee toe.

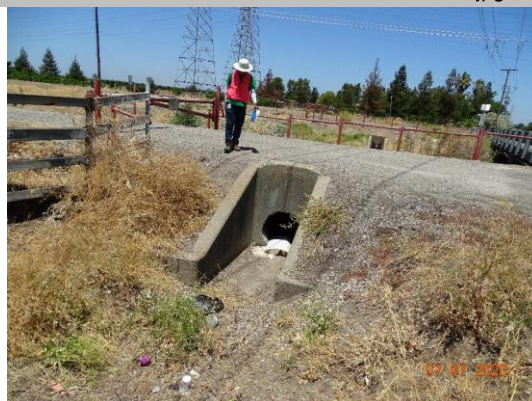
Photo 2 of 3 : UCIP_FA_2021_59613_87121.jpg

View of pipe inlet and headwall located at the LS levee toe.

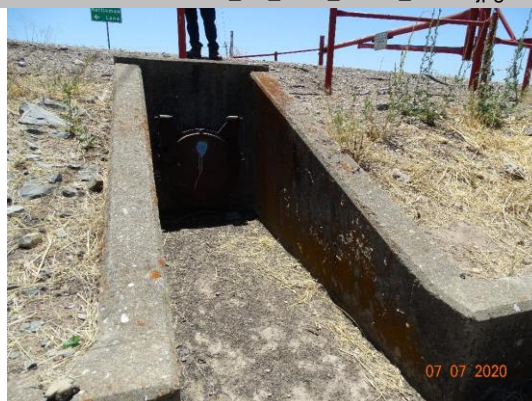
Photo 3 of 3 : UCIP_FA_2021_59613_87122.jpg

View of pipe outlet, flap gate, and headwall located at the WS levee toe.

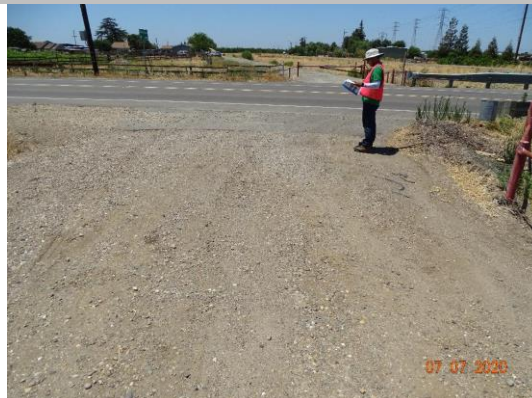
Photo 1 of 3 : UCIP_FA_2021_59617_87134.jpg

Comment Code						
Inspector Comment						
DS_ID:23909 FS_ID:59617 EP_NO: N/A Repair Type: Non-Urgent EVAL Issue: Unauthorized Encroachment, installed decades prior Crossing Status: Found UCIP Comments: 07/07/2020 Crossing evaluated as "Non-Urgent" because there was no permit found authorizing this pipe. (A. McDonald - DWR UCIP) FIELD_STRUCT_DESC: 24-inch corrugated metal drainage pipe through the levee, 5 feet below the crown. Concrete U-shaped headwalls on both ends. Flap gate on the waterside (WS) end. Cobble grouted spillway. Cobble grouted intake on the landside (LS). [Additional Reference(s): DWR Levee Log, 1978. USACE San Joaquin O&M Manual 612.2, 1967, (HLM 2.16)]. FS Date: 7/7/2020

Overview of levee crown looking d/s.

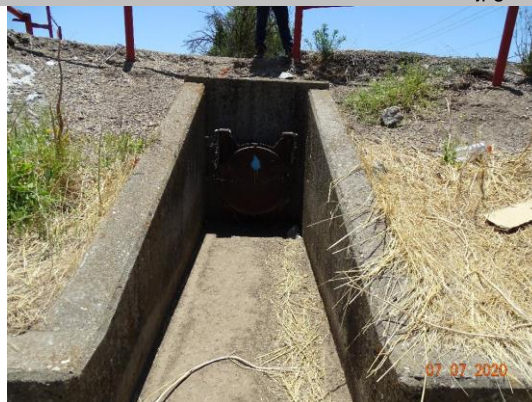
Photo 2 of 3 : UCIP_FA_2021_59617_87135.jpg

View of pipe outlet, flap gate, and headwall located at the WS levee toe.

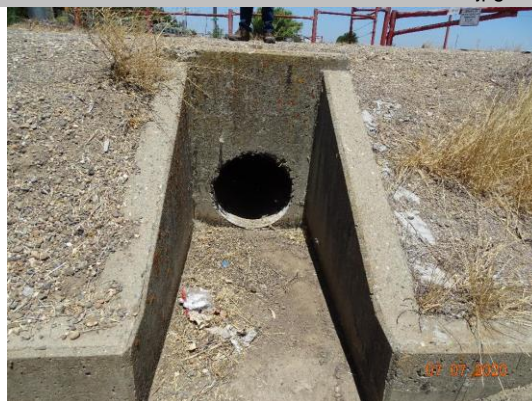
Photo 3 of 3 : UCIP_FA_2021_59617_87136.jpg

View of pipe inlet and headwall located at the LS levee toe.

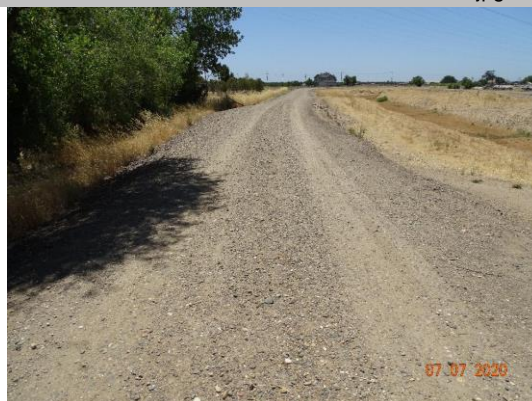
Photo 1 of 3 : UCIP_FA_2021_59624_87162.jpg

DS_ID:23911
 FS_ID:59624
 EP_NO: N/A
 Repair Type: Non-Urgent
 EVAL Issue: Unauthorized Encroachment, installed decades prior
 Crossing Status: Found
 UCIP Comments: 07/07/2020 Crossing evaluated as "Non-Urgent" because there was no permit found authorizing this pipe. (A. McDonald - DWR UCIP)
 FIELD_STRUCT_DESC: 24-inch corrugated metal drainage pipe through the levee, 6 feet below the crown. Concrete U-shaped headwalls on both ends. Flap gate on the waterside (WS) end. Cobble grouted spillway. Cobble grouted intake on the landside (LS).
 [Additional Reference(s): DWR Levee Log, 1978. USACE San Joaquin O&M Manual 612.2, 1967, (HLM 2.36)].
 FS Date: 7/7/2020

Overview of levee crown looking d/s.

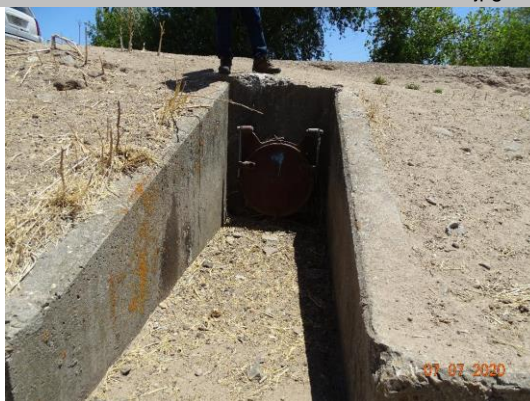
Photo 2 of 3 : UCIP_FA_2021_59624_87163.jpg

View of pipe outlet, flap gate, and headwall located at the WS levee toe.

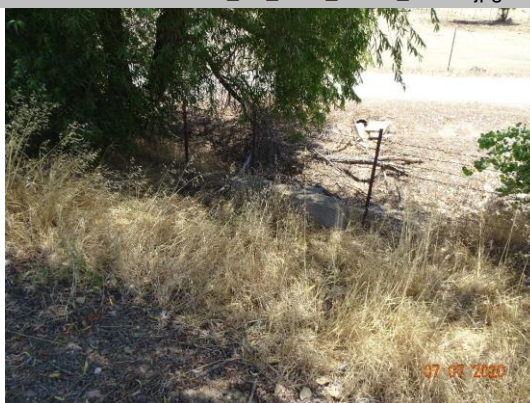
Photo 3 of 3 : UCIP_FA_2021_59624_87164.jpg

View of pipe inlet and headwall located at the LS levee toe.

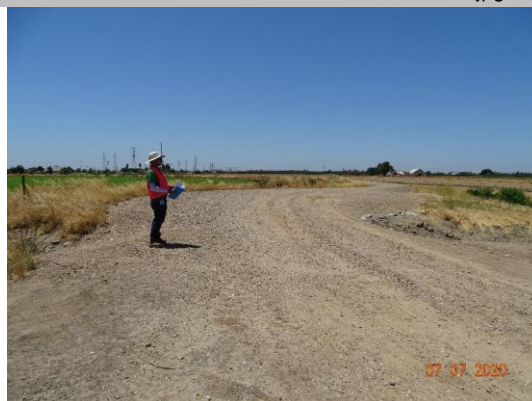
Photo 1 of 3 : UCIP_FA_2021_59626_87169.jpg

Comment Code						
Inspector Comment						
DS_ID:23913 FS_ID:59626 EP_NO: N/A Repair Type: Non-Urgent EVAL Issue: Unauthorized Encroachment, installed decades prior Crossing Status: Found UCIP Comments: 07/07/2020 Crossing evaluated as "Non-Urgent" because there was no permit found authorizing this pipe. (A. McDonald - DWR UCIP)11/04/2016 Crossing has been downgraded from Urgent to Non-Urgent the silt buildup in front of the flap gate on the WS has been removed, however the sediment buildup inside the crossing still remains. Recommend clearing the sediment buildup inside the pipe and complete an internal integrity inspection to confirm crossing is in good condition. (O. Magana - DWR UCIP) 06/19/2014 Silt buildup on WS toe blocking flap gate operation. (W. Wylie - DWR UCIP) FIELD_STRUCT_DESC: 24-inch corrugated metal drainage pipe through the levee, 4 feet below the crown. Flap gate is located on the waterside (WS) end with a cobble grouted spillway. Cobble grouted intake on the landside (LS). [Additional Reference(s): DWR Levee Log, 1978. USACE San Joaquin O&M Manual Unit 612.2, 1967, (HLM 2.61)]. FS Date: 7/7/2020

Overview of levee crown looking d/s.

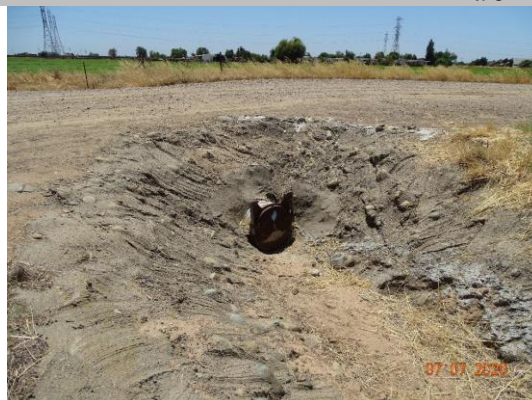
Photo 2 of 3 : UCIP_FA_2021_59626_87170.jpg

View of pipe outlet and spillway located at the WS levee toe.

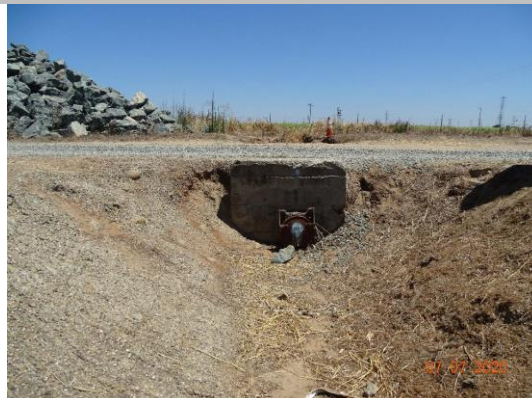
Photo 2 of 3 : UCIP_FA_2021_59630_87212.jpg

View of pipe outlet, flap gate, and headwall located at the WS levee toe.

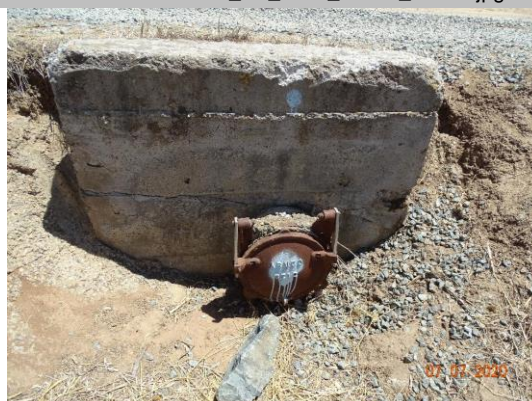
Photo 3 of 3 : UCIP_FA_2021_59630_87213.jpg

View of pipe outlet, flap gate, and headwall located at the WS levee toe.

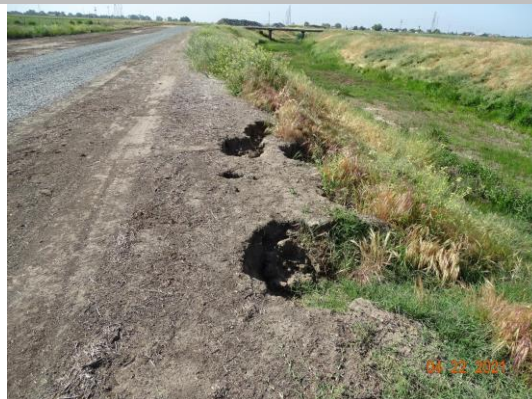
Photo 1 of 1 : FA_2021_NA0017_156_32_20210913_00003.jpg

LM Start	2.92	Rating **	M	Issue No.	32
LM End	2.92	Issue Type +	Ma	Location *	WS
Category	Earthen Levee			GPS Latitude/Longitude	
				Start	End
Item	Erosion / Bank Caving			38.125622 °	38.125622 °
				-121.143888 °	-121.143888 °
DWR ID	DWR_NA0017_12_s_2021_32				
Comment Code					
E2 : Schedule repair of erosion site prior to the next inspection.					
Inspector Comment					
This area is considered high ground, there is bank erosion near waterside hinge point, approximately 20 feet long, 12-18 inched deep and 3 feet wide. Spring 2021

View of erosion near the waterside hinge point. Spring 2021

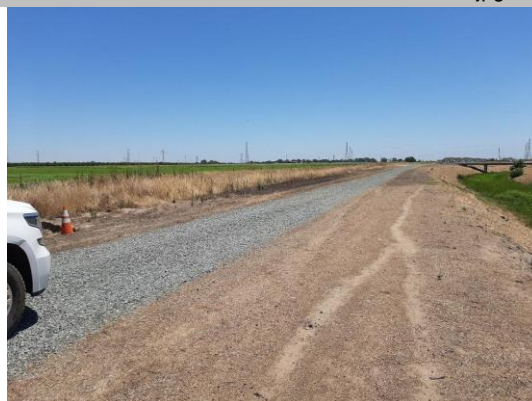
Photo 1 of 3 : UCIP_FA_2021_59632_87220.jpg

Comment Code						
Inspector Comment						
DS_ID:23916 FS_ID:59632 EP_NO: N/A Repair Type: No Action Needed EVAL Issue: Compliant Crossing Status: Found UCIP Comments: 07/03/2020 Crossing evaluated as "No Action Needed." Permit and inspection requirements have been met. (A. McDonald - DWR UCIP) FIELD_STRUCT_DESC: 12-inch corrugated metal drainage pipe through the levee, 3 feet below the crown. Flap gate on the waterside (WS) end. Cobble grouted spillway. (Positive closure device installed on intake end under Permit No. 17426, 2003 - Western Dairy Design Associates, Inc.). [Additional Reference(s): DWR Levee Log, 1978. USACE San Joaquin O&M Manual 612.2, 1967, (HLM 2.95)]. FS Date: 7/3/2020

Overview of levee crown looking d/s.

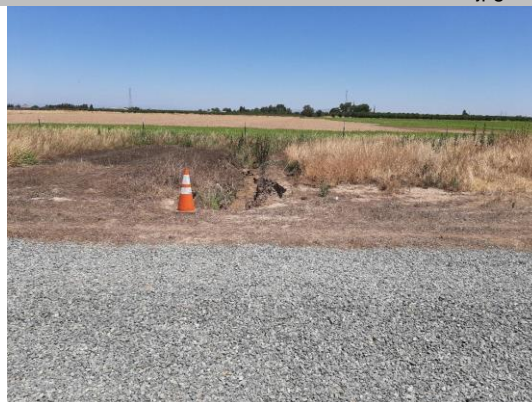
Photo 2 of 3 : UCIP_FA_2021_59632_87222.jpg

Overview of the LS and pipe inlet location.

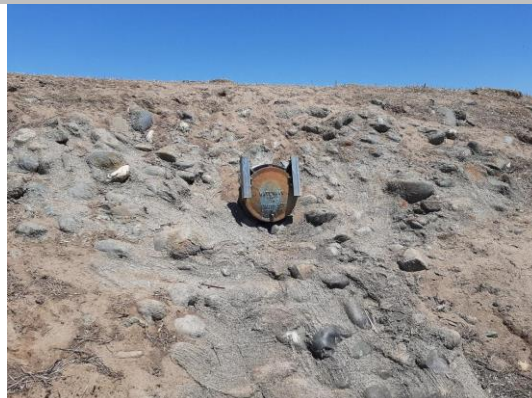
Photo 3 of 3 : UCIP_FA_2021_59632_87221.jpg

View of pipe outlet, flap gate, and splash apron located at the WS levee toe.

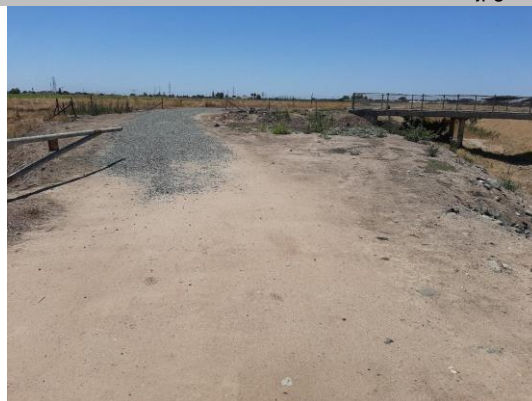
Photo 1 of 3 : UCIP_FA_2021_59674_87230.jpg

DS_ID:23928
FS_ID:59674
EP_NO: N/A
Repair Type: Urgent
EVAL Issue: Pipe Integrity
Crossing Status: Found
UCIP Comments: 07/03/2020 Crossing evaluated as "Urgent" because of a badly deteriorated drainage pipe that is also open on both ends. There was no permit found authorizing this pipe, either. (A. McDonald - DWR UCIP)11/12/2018 NA0017 found corrosion and holes along the bottom of this CMP drainage culvert. Culvert is also open on both ends. Crossing escalated to "Urgent" due to the extensive corrosion that was found. Internal inspection and/or rehabilitation recommended. (A. McDonald - DWR UCIP)Pipe open on both ends.
FIELD_STRUCT_DESC: 1 of 2: 24-inch corrugated metal drainage pipe through the levee, 3 feet below the crown. No closure device or flap gate. [Additional Reference(s): USACE San Joaquin O&M Manual 612.2, 1967, (HLM 3.15)].
FS Date: 7/3/2020

Overview of levee crown looking d/s.

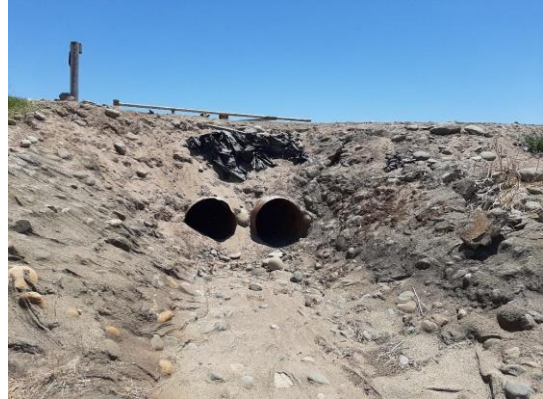
Photo 2 of 3 : UCIP_FA_2021_59674_87231.jpg

View of two drainage pipe outlets located at the WS levee toe.

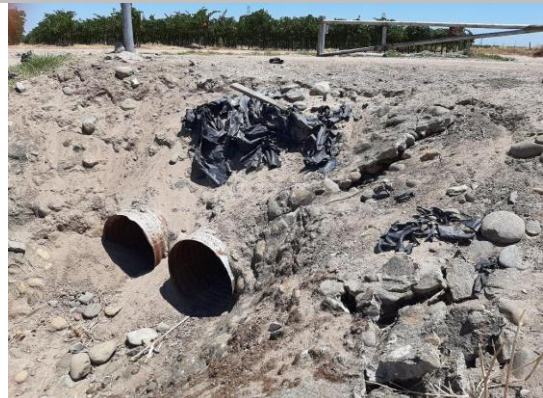
Photo 3 of 3 : UCIP_FA_2021_59674_87232.jpg

View of two drainage pipe outlets located at the WS levee toe.

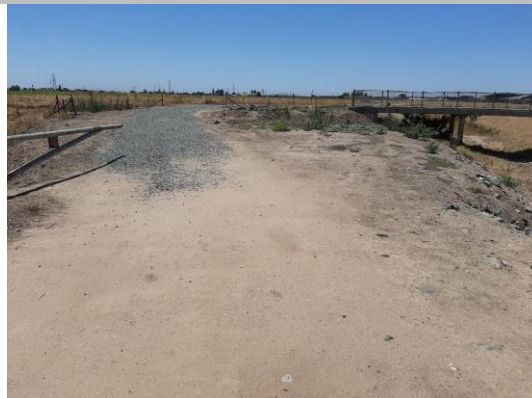
Photo 1 of 3 : UCIP_FA_2021_59675_87241.jpg

Comment Code						
Inspector Comment						
DS_ID:23926 FS_ID:59675 EP_NO: N/A Repair Type: Urgent EVAL Issue: Pipe Integrity Crossing Status: Found UCIP Comments: 07/03/2020 Crossing evaluated as "Urgent" because of a badly deteriorated drainage pipe that is also open on both ends. There was no permit found authorizing this pipe, either. (A. McDonald - DWR UCIP)11/12/2018 NA0017 found corrosion and holes along the bottom of this CMP drainage culvert. Culvert is also open on both ends. Crossing escalated to "Urgent" due to the extensive corrosion that was found. Internal inspection and/or rehabilitation recommended. (A. McDonald - DWR UCIP)Pipe open with no flap gate. FIELD_STRUCT_DESC: 2 of 2: 24-inch corrugated metal drainage pipe through the levee, 3 feet below the crown. No closure device or flap gate. [Additional Reference(s): USACE San Joaquin O&M Manual 612.2, 1967, (HLM 3.15)]. FS Date: 7/3/2020

Overview of levee crown looking d/s.

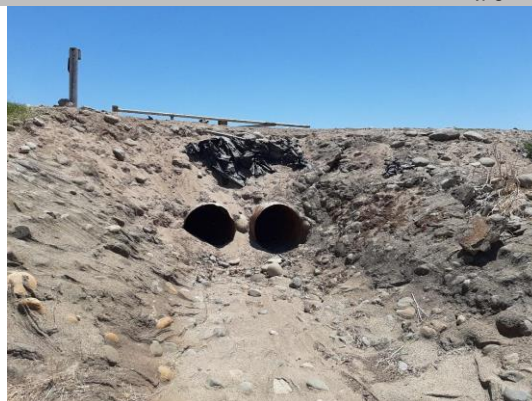
Photo 2 of 3 : UCIP_FA_2021_59675_87242.jpg

View of two drainage pipe outlets located at the WS levee toe.

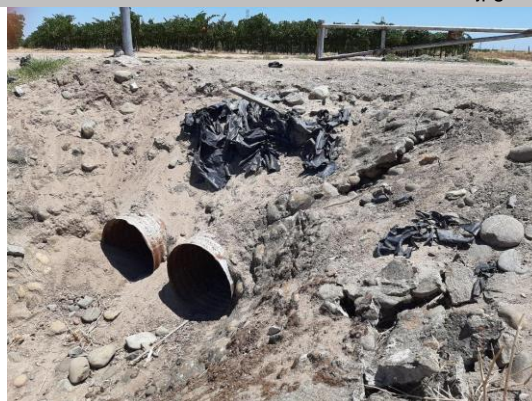
Photo 3 of 3 : UCIP_FA_2021_59675_87243.jpg

View of two drainage pipe outlets located at the WS levee toe.

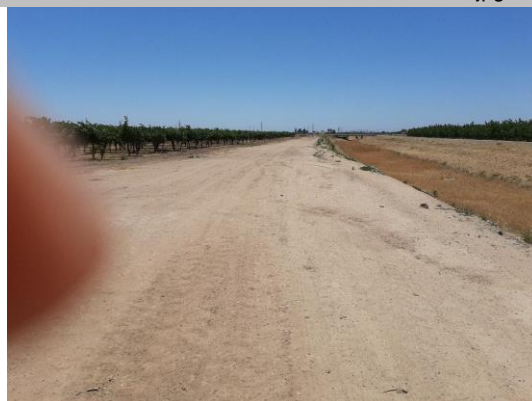
Photo 1 of 3 : UCIP_FA_2021_59676_87247.jpg

DS_ID:23917
 FS_ID:59676
 EP_NO: N/A
 Repair Type: Urgent
 EVAL Issue: Flood Risk
 Crossing Status: Found
 UCIP Comments: 07/03/2020 Crossing evaluated as "Urgent" because it is a straight-through drainage pipe with no flap gate on the WS end. There was also no permit found authorizing this pipe. (A. McDonald - DWR UCIP)No flap gate.
 FIELD_STRUCT_DESC: 24-inch corrugated metal drainage pipe through the levee, 4.5 feet below the crown. Cobble grouted spillway. Cobble grouted intake on the landside (LS). [Additional Reference(s): DWR Levee Log, 1978. USACE San Joaquin O&M Manual 612.2, 1967, (HLM 3.25)].
 FS Date: 7/3/2020

Overview of levee crown looking d/s.

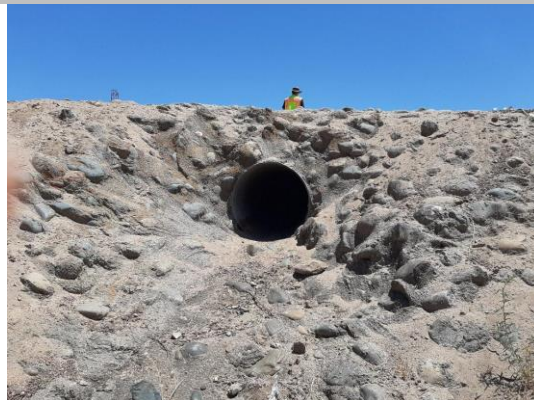
Photo 2 of 3 : UCIP_FA_2021_59676_87248.jpg

View of pipe outlet and splash apron located at the WS levee toe.

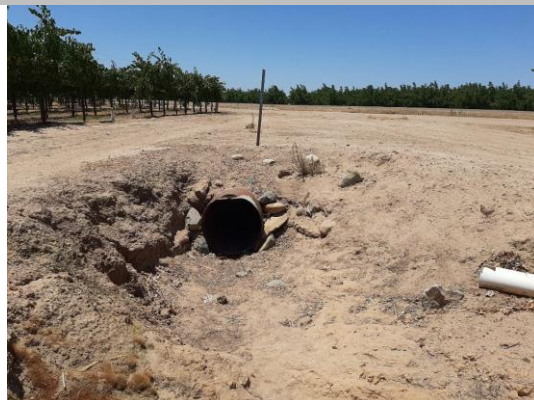
Photo 3 of 3 : UCIP_FA_2021_59676_87249.jpg

View of pipe inlet located 50 to 100 feet off the LS levee toe.

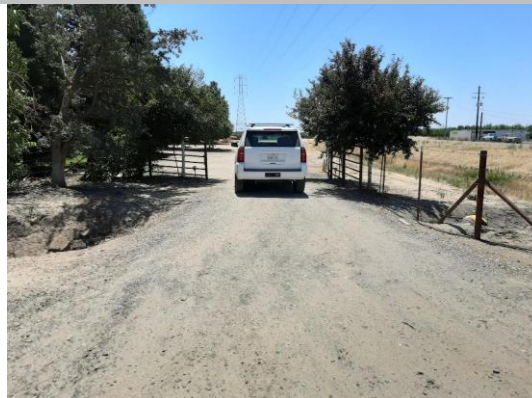
Photo 1 of 3 : UCIP_FA_2021_59638_87257.jpg

LM Start	3.51	Rating **	M	Issue No.	81	
LM End	3.51	Issue Type +	Ma	Location *		
Category	Supplemental			GPS Latitude/Longitude		
				Start		End
Item	DWR UCIP LMA Responsibility			38.131725 °		38.131725 °
				-121.138422 °		-121.138422 °
DWR ID	23920					
Comment Code						
Inspector Comment						
DS_ID:23920 FS_ID:59638 EP_NO: N/A Repair Type: Non-Urgent EVAL Issue: Unauthorized Encroachment, installed decades prior Crossing Status: Found UCIP Comments: 07/03/2020 Crossing evaluated as "Non-Urgent" because there was no permit found authorizing this pipe. Video inspection performed on 04-22-2020. (A. McDonald - DWR UCIP) FIELD_STRUCT_DESC: 12-inch corrugated metal drainage pipe through the levee, 4.5 feet below the crown. Cobble grouted spillway. [Additional Reference(s): DWR Levee Log, 1978. USACE San Joaquin O&M Manual 612.2, 1967, (HLM 3.52)]. FS Date: 7/3/2020

Overview of levee crown looking d/s.
