**Flood Control Project Maintenance
Levee Inspections**

Maintenance Issue Types Only, Levee Inspection Report By Mile - Fall 2021

San Joaquin County Flood Control and Water Conservation District

Waterway	Bank	Unit Miles	Inspection Start/End	Inspector
Unit No. 01 Littlejohn Creek	Left	2.59	10/21/2021 10/21/2021	Alberto De Leon

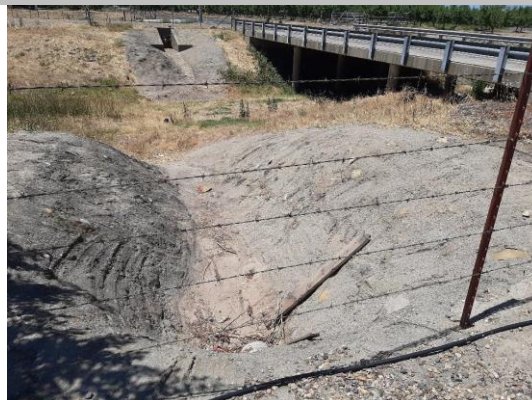
Photo 2 of 3 : UCIP_FA_2021_59638_87258.jpg

LM Start	3.51	Rating **	M	Issue No.	81	
LM End	3.51	Issue Type +	Ma	Location *		
Category	Supplemental			GPS Latitude/Longitude		
				Start		End
Item	DWR UCIP LMA Responsibility			38.131725 °		38.131725 °
				-121.138422 °		-121.138422 °
DWR ID	23920					
Comment Code						
Inspector Comment						
DS_ID:23920 FS_ID:59638 EP_NO: N/A Repair Type: Non-Urgent EVAL Issue: Unauthorized Encroachment, installed decades prior Crossing Status: Found UCIP Comments: 07/03/2020 Crossing evaluated as "Non-Urgent" because there was no permit found authorizing this pipe. Video inspection performed on 04-22-2020. (A. McDonald - DWR UCIP) FIELD_STRUCT_DESC: 12-inch corrugated metal drainage pipe through the levee, 4.5 feet below the crown. Cobble grouted spillway. [Additional Reference(s): DWR Levee Log, 1978. USACE San Joaquin O&M Manual 612.2, 1967, (HLM 3.52)]. FS Date: 7/3/2020

View of WS channel and splash apron.

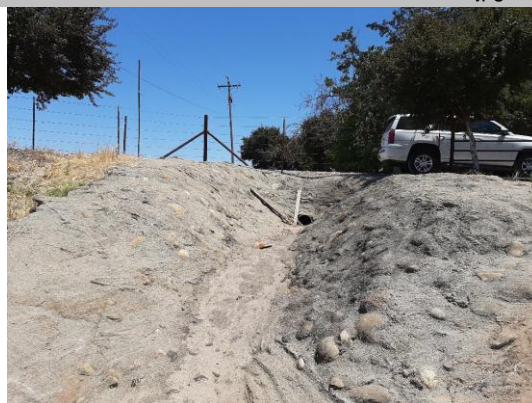
Photo 3 of 3 : UCIP_FA_2021_59638_87259.jpg

View of pipe outlet and splash apron located at the WS levee toe.

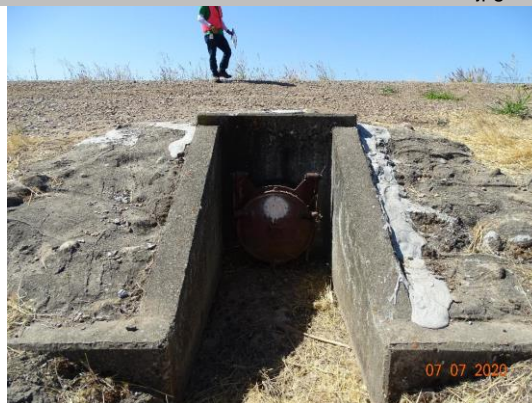
Photo 2 of 3 : UCIP_FA_2021_58900_86686.jpg

Comment Code					
Inspector Comment					
DS_ID:23931 FS_ID:58900 EP_NO: N/A Repair Type: Non-Urgent EVAL Issue: Crossing Status: Found UCIP Comments: 07/07/2020 Record upgraded from No Action Needed to Non Urgent because no permit has been identified authorizing pipe. This is s system feature without any modification to system. Same observation as last inspection. Pipe is in good condition. Video Inspection was performed in 4/24/2020 and the result will be appended to this report when it becomes available. (S.Donovan - DWR UCIP) FIELD_STRUCT_DESC: 24-inch corrugated metal drainage pipe through the levee, 5.5 feet below the crown. Concrete U-shaped headwall on both ends. Flap gate on the waterside (WS) end. [Additional Reference(s): DWR Levee Log, 1978. USACE San Joaquin O&M Manual 612.2, 1967, (HLM 0.03)]. FS Date: 7/7/2020

Water-Side: View of pipe, headwall, and flapgate.

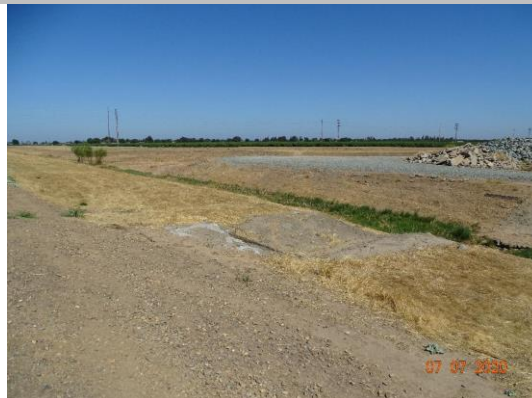
Photo 3 of 3 : UCIP_FA_2021_58900_86687.jpg

Water-Side: View of headwall, spillway and channel.

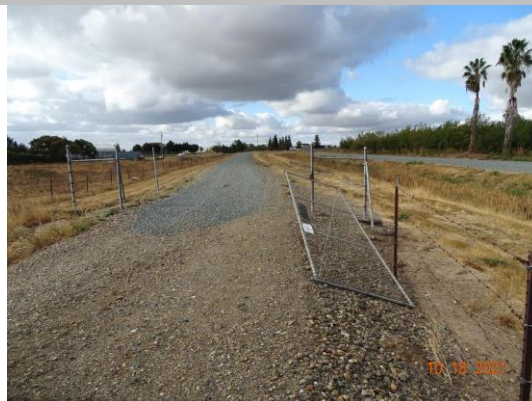
Photo 1 of 1 : FA_2021_NA0017_157_13_20211018_00031.jpg

LM Start	0.55	Rating **	M	Issue No.	13
LM End	0.55	Issue Type +	Ma	Location *	CR
Category	Earthen Levee			GPS Latitude/Longitude	
				Start	End
Item	Repair Gates			38.110887 °	38.110887 °
				-121.151027 °	-121.151027 °
DWR ID	DWR_NA0017_13_f_2021_13				
Comment Code					
Inspector Comment

View of damaged gate. Fall 2021

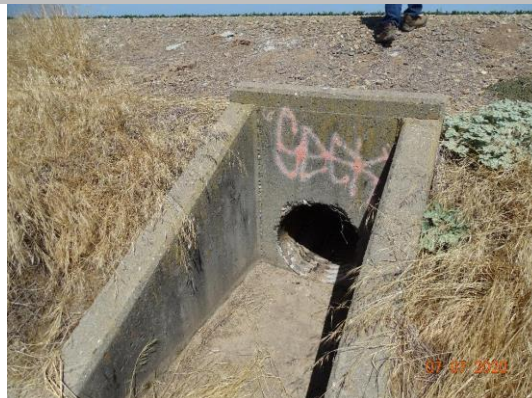
Photo 2 of 3 : UCIP_FA_2021_58907_86750.jpg

Land-Side: view of pipe and headwall.

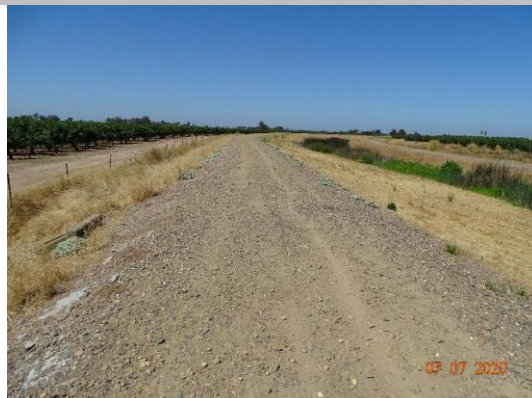
Photo 3 of 3 : UCIP_FA_2021_58907_86751.jpg

Overview of Levee: View of levee crown looking downstream.

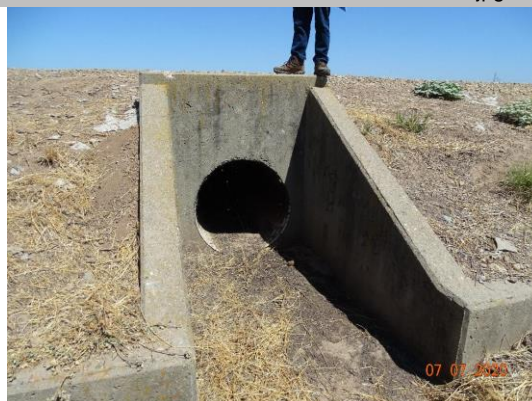
Photo 3 of 3 : UCIP_FA_2021_58908_86753.jpg

Land-Side: view of pipe and headwall.

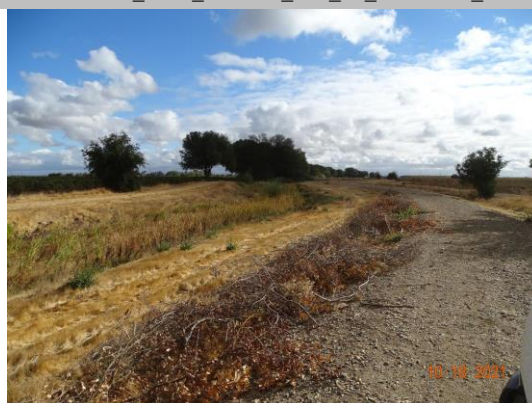
Photo 1 of 1 : FA_2021_NA0017_157_10_20211018_00030.jpg

LM Start	1.31	Rating **	M	Issue No.	10
LM End	1.31	Issue Type +	Ma	Location *	WS
Category	Earthen Levee			GPS Latitude/Longitude	
				Start	End
Item	Encroachments			38.110667 °	38.110667 °
				-121.140114 °	-121.140114 °
DWR ID	DWR_NA0017_13_f_2021_10				
Comment Code					
PR : Prunings					
Inspector Comment

View of prunings along the waterside slope. Fall 2021

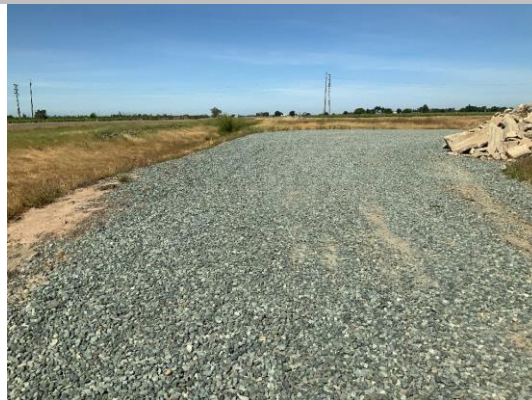
Photo 1 of 3 : UCIP_FA_2021_66838_98394.jpg

Comment Code						
Inspector Comment						
DS_ID:23939 FS_ID:66838 EP_NO: N/A Repair Type: Non-Urgent EVAL Issue: Unauthorized Encroachment, installed decades prior Crossing Status: Found UCIP Comments: 04/29/2021 Record has been upgraded from No Action Needed to Non-Urgent. Unit 14 – Middle Paddle Creek (CLM 0 to 1.38) is considered a patrol road/high ground area with no defined levee prism, any issue found between CLM 0 to 1.38 of Unit 14 will be considered a maintenance issue, or an unauthorized encroachment, or an abandoned encroachment. DWR DMP internal inspection has not found pipe integrity issues. LOF of crossing is less or equal to 4.0. Recommend next inspection in 5 years. Current condition of pipe crossing does not impede access to patrol road/high ground area. No permit was found authorizing this encroachment. CVFPB will need to review crossing to determine owner. The UCIP inspection was completed with LMA representative, J. Nelson. (H. Dunn – GEI) FIELD_STRUCT_DESC: 12-inch corrugated metal drainage pipe through the levee, 3 feet below the crown. Flap gate on the waterside (WS) end. Cobble grouted spillway. Cobble grouted intake on the landside (LS). [Additional Reference(s): DWR Levee Log, 1978. USACE San Joaquin O&M Manual 612.2, 1967, (HLM 0.02)]. FS Date: 4/29/2021

Levee crown looking downstream.

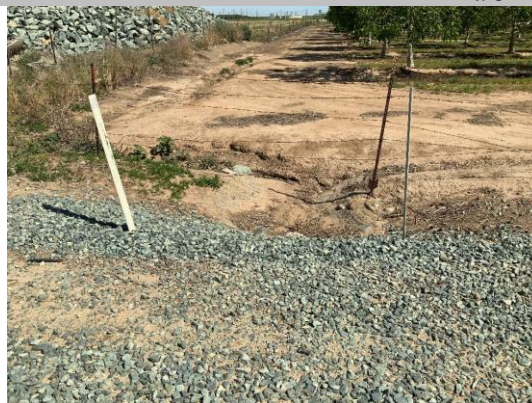
Photo 2 of 3 : UCIP_FA_2021_66838_98395.jpg

LS view: Toe from crown.

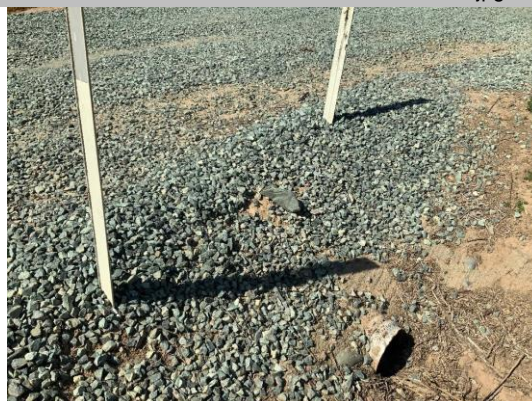
Photo 3 of 3 : UCIP_FA_2021_66838_98396.jpg

LS view: Slope and pipe inlet at toe.

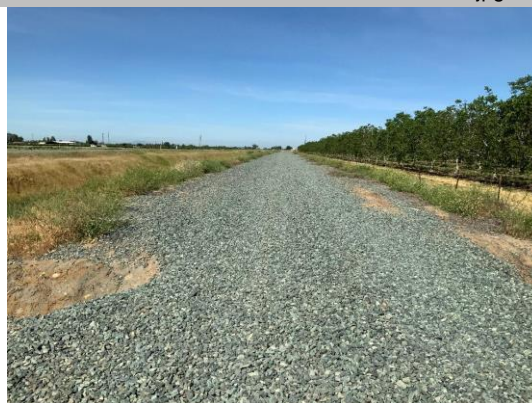
Photo 1 of 3 : UCIP_FA_2021_66868_98400.jpg

Levee crown looking downstream.

Comment Code					
Inspector Comment					
DS_ID:23940 FS_ID:66868 EP_NO: N/A Repair Type: Non-Urgent EVAL Issue: Unauthorized Encroachment, installed decades prior Crossing Status: Found UCIP Comments: 04/29/2021 Pipe status is still Non-Urgent. Unit 14 ? Middle Paddle Creek (CLM 0 to 1.38) is considered a patrol road/high ground area with no defined levee prism, any issue found between CLM 0 to 1.38 of Unit 14 will be considered a maintenance issue, or an unauthorized encroachment, or an abandoned encroachment. DWR DMP internal inspection has not found pipe integrity issues. LOF of crossing is less or equal to 4.0. Recommend inspection in 5 years. Current condition of pipe crossing does not impede access to patrol road/high ground area. No permit was found authorizing this encroachment. CVFPB will need to review crossing to determine owner. The UCIP inspection was completed with LMA representative, J. Nelson. (H. Dunn ? GEI) 06/12/2014 Debris partially blocking closure of flapgate. (W. Wylie - DWR UCIP) FIELD_STRUCT_DESC: 12-inch corrugated metal drainage pipe through the levee, 3 feet below the crown. Flap gate on the waterside (WS) end. Cobble grouted spillway. [Additional Reference(s): DWR Levee Log, 1978. USACE San Joaquin O&M Manual 612.2, 1967, (HLM 0.25)]. FS Date: 4/29/2021

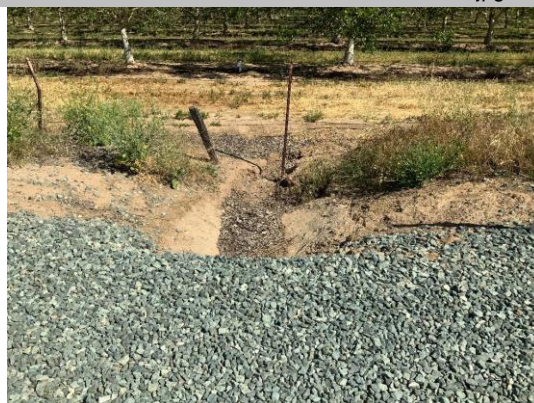
Photo 2 of 3 : UCIP_FA_2021_66868_98401.jpg

LS view: Toe from crown.

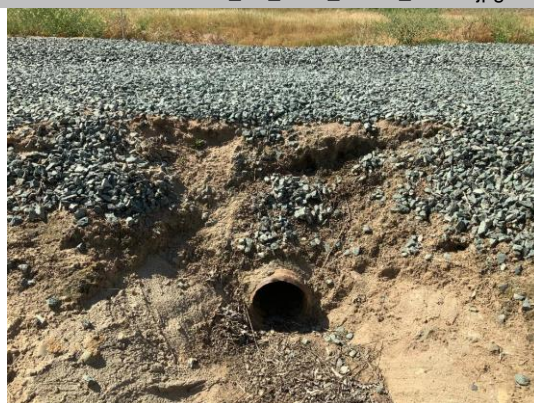
Photo 3 of 3 : UCIP_FA_2021_66868_98402.jpg

LS view: Slope and pipe inlet at toe.

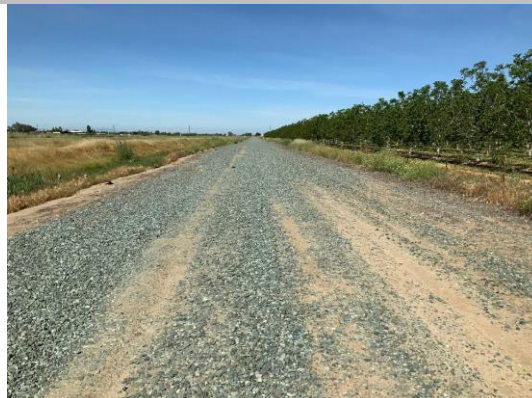
Photo 1 of 3 : UCIP_FA_2021_66871_98406.jpg

Comment Code						
Inspector Comment						
DS_ID:23941 FS_ID:66871 EP_NO: N/A Repair Type: Non-Urgent EVAL Issue: Maintenance Compliance Issue Crossing Status: Found UCIP Comments: 04/29/2021 Pipe status is still Non-Urgent. Unit 14 – Middle Paddle Creek (CLM 0 to 1.38) is considered a patrol road/high ground area with no defined levee prism, any issue found between CLM 0 to 1.38 of Unit 14 will be considered a maintenance issue, or an unauthorized encroachment, or an abandoned encroachment. DWR DMP internal inspection has not found pipe integrity issues. LOF of crossing is less or equal to 4.0. Recommend inspection in 5 years. Current condition of pipe crossing does not impede access to patrol road/high ground area. Pipe is open on both ends without a flapgate and LS pipe edges are warped, recommend maintenance. No permit was found authorizing this encroachment. CVFPB will need to review crossing to determine owner. The UCIP inspection was completed with LMA representative, J. Nelson. (H. Dunn – GEI) 06/12/2014 Pipe buried on WS slope. (W. Wylie - DWR UCIP) FIELD_STRUCT_DESC: 12-inch corrugated metal drainage pipe through the levee, 1 foot below the crown. Flap gate on the waterside (WS) end. Cobble grouted spillway. [Additional Reference(s): DWR Levee Log, 1978. USACE San Joaquin O&M Manual 612.2, 1967, (HLM 0.38)]. FS Date: 4/29/2021

Levee crown looking downstream.

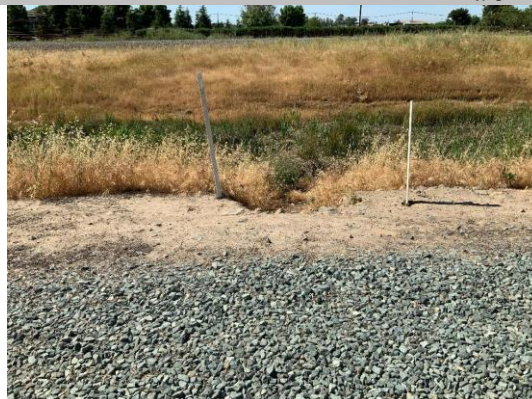
Photo 2 of 3 : UCIP_FA_2021_66871_98407.jpg

WS view: Toe from crown with markers on either side.

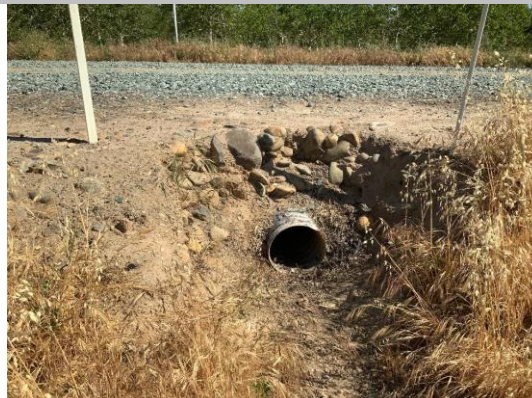
Photo 3 of 3 : UCIP_FA_2021_66871_98408.jpg

WS view: Slope and pipe outlet at toe, no flapgate.

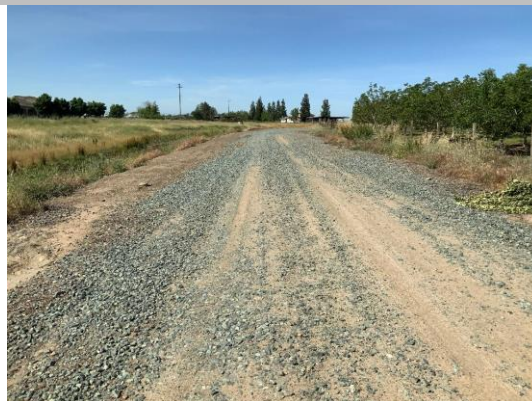
Photo 1 of 3 : UCIP_FA_2021_66872_98412.jpg

DS_ID:23942
FS_ID:66872
EP_NO: N/A
Repair Type: Non-Urgent
EVAL Issue: Unauthorized Encroachment, installed decades prior
Crossing Status: Found
UCIP Comments: 04/29/2021 Record has been upgraded from No Action Needed to Non-Urgent. Unit 14 – Middle Paddle Creek (CLM 0 to 1.38) is considered a patrol road/high ground area with no defined levee prism, any issue found between CLM 0 to 1.38 of Unit 14 will be considered a maintenance issue, or an unauthorized encroachment, or an abandoned encroachment. DWR DMP internal inspection has not found pipe integrity issues. LOF of crossing is less or equal to 4.0. Recommend inspection in 5 years. Current condition of pipe crossing does not impede access to patrol road/high ground area. No permit was found authorizing this encroachment. CVFPB will need to review crossing to determine owner. The UCIP inspection was completed with LMA representative, J. Nelson. (H. Dunn – GEI)

FIELD_STRUCT_DESC: 12-inch corrugated metal drainage pipe through the levee, 2 feet below the crown. Flap gate on the waterside (WS) end. Cobble grouted spillway. Cobble grouted intake on the landside (LS). [Additional Reference(s): DWR Levee Log, 1978. USACE San Joaquin O&M Manual 612.2, 1967, (HLM 0.46)].
FS Date: 4/29/2021

Levee crown looking downstream.

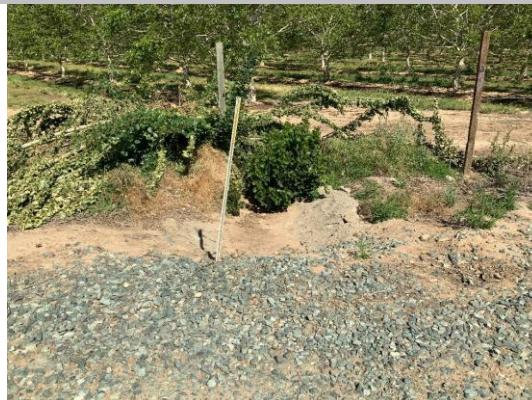
Photo 2 of 3 : UCIP_FA_2021_66872_98413.jpg

LS view: Toe from crown, marker visible.

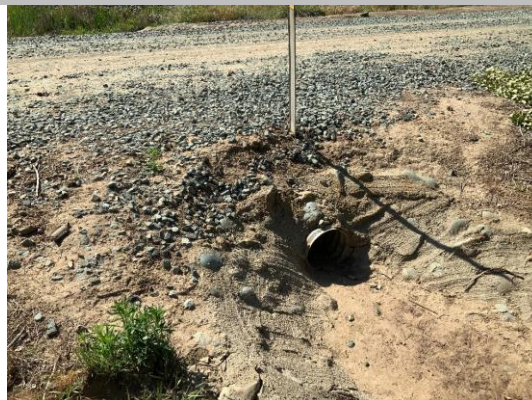
Photo 3 of 3 : UCIP_FA_2021_66872_98414.jpg

LS view: Slope and pipe inlet at toe.

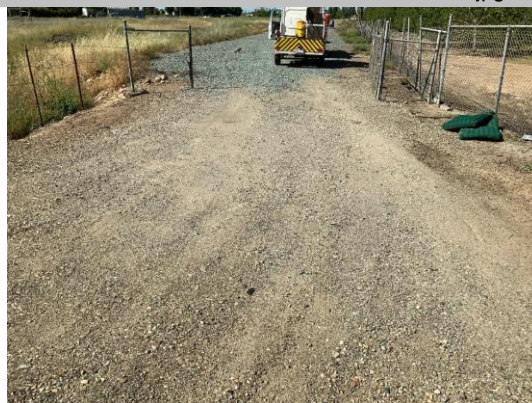
Photo 1 of 3 : UCIP_FA_2021_66873_98421.jpg

DS_ID:23943
FS_ID:66873
EP_NO: N/A
Repair Type: Non-Urgent
EVAL Issue: Maintenance Compliance Issue
Crossing Status: Found
UCIP Comments: 04/29/2021 Pipe status is still Non-Urgent. Unit 14 – Middle Paddle Creek (CLM 0 to 1.38) is considered a patrol road/high ground area with no defined levee prism, any issue found between CLM 0 to 1.38 of Unit 14 will be considered a maintenance issue, or an unauthorized encroachment, or an abandoned encroachment. DWR DMP internal inspection has not found pipe integrity issues. LOF of crossing is less or equal to 4.0. Recommend inspection in 5 years. Current condition of pipe crossing does not impede access to patrol road/high ground area. Pipe is open on both ends and there is some erosion around pipe on both WS and LS ends, recommend maintenance for erosion. No permit was found authorizing this encroachment. CVFPB will need to review crossing to determine owner. The UCIP inspection was completed with LMA representative, J. Nelson. (H. Dunn – GEI) 09/18/2018 Pipe is close to the crown. It may not create a serious situation. Maintenance required by owner at pipe inlet. Crossing downgraded to "Non-Urgent." (A. McDonald - DWR UCIP)11/04/2016 Same as previous inspection. Crossing remains Urgent crossing, open on both ends. (O. Magana - DWR UCIP)06/12/2014 Pipe inlet and outlet partially blocked by sediment. No flapgate. (W. Wylie - DWR UCIP)

FIELD_STRUCT_DESC: 18-inch corrugated metal drainage pipe through the levee, 2.5 feet below the crown. Pipe open on both ends. Inlet is located at the end of a drainage ditch along the road. Cobble grouted spillway on the waterside (WS). [Additional Reference(s): DWR Levee Log, 1977, 1978, 1987, 1990. USACE San Joaquin O&M Manual Unit 612, Part No. 2 - Bear Creel Project, Unit 7: HLM 7.19 – 16.77, Unit 8: HLM 7.55-16.48, Unit 9: HLM 0.10-1.52; Unit 10: HLM 0.03-1.35, Unit 11: HLM 0.16-3.55, Unit 12: HLM 0.14-3.91; Unit 13, HLM 0.03-1.18; Unit 14, HLM 0.02-1.17, 1967, (HLM 0.55)].
FS Date: 4/29/2021

Levee crown looking downstream.

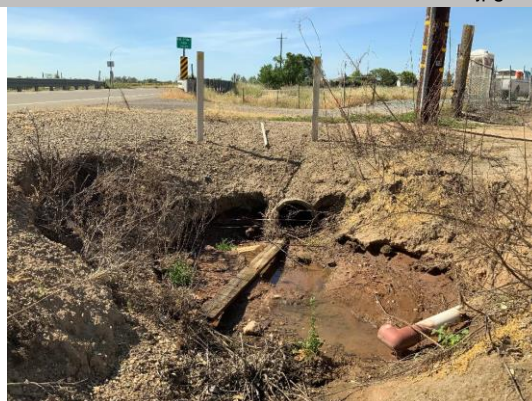
Photo 2 of 3 : UCIP_FA_2021_66873_98419.jpg

LS view: Slope and pipe inlet at toe.

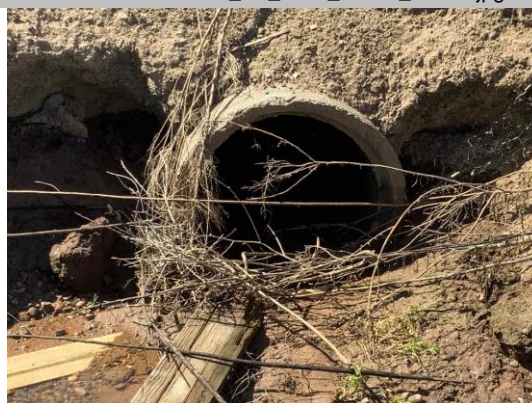
Photo 3 of 3 : UCIP_FA_2021_66873_98420.jpg

LS view: Close up of pipe inlet at toe, some erosion around pipe.

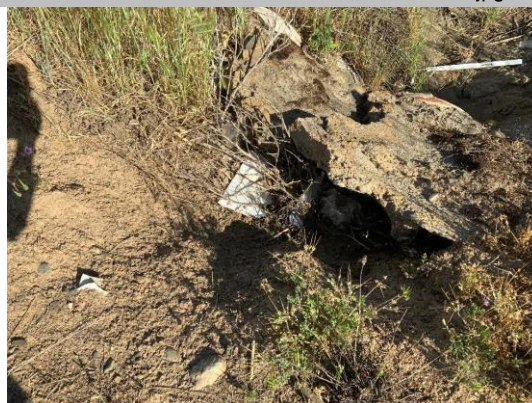
Photo 3 of 3 : UCIP_FA_2021_66877_98440.jpg

Comment Code						
Inspector Comment						
DS_ID:23944 FS_ID:66877 EP_NO: N/A Repair Type: Non-Urgent EVAL Issue: Maintenance Compliance Issue Crossing Status: Found UCIP Comments: 04/29/2021 Record has been upgraded from No Action Needed to Non-Urgent. Unit 14 – Middle Paddle Creek (CLM 0 to 1.38) is considered a patrol road/high ground area with no defined levee prism, any issue found between CLM 0 to 1.38 of Unit 14 will be considered a maintenance issue, or an unauthorized encroachment, or an abandoned encroachment. DWR DMP internal inspection has found pipe integrity issues. LOF of crossing is between 5 and 6. Crossing will be monitored until funding becomes available to address the issues. Current condition of pipe crossing does not impede access to patrol road/high ground area. Pipe is open on both ends, no flapgate. Erosion and gapping to the side and above LS pipe inlet, recommend maintenance. No permit was found authorizing this encroachment. CVFPB will need to review crossing to determine owner. The UCIP inspection was completed with LMA representative, J. Nelson. (H. Dunn – GEI) FIELD_STRUCT_DESC: 18-inch corrugated metal drainage pipe under the road, 2.5 feet below the crown. Open on both ends. Cobble grouted spillway. Cobble grouted intake on the landside (LS). [Additional Reference(s): DWR Levee Log, 1978. USACE San Joaquin O&M Manual 612.2, 1967, (HLM 0.57)]. FS Date: 4/29/2021

LS view: Erosion and gapping above pipe inlet on slope.

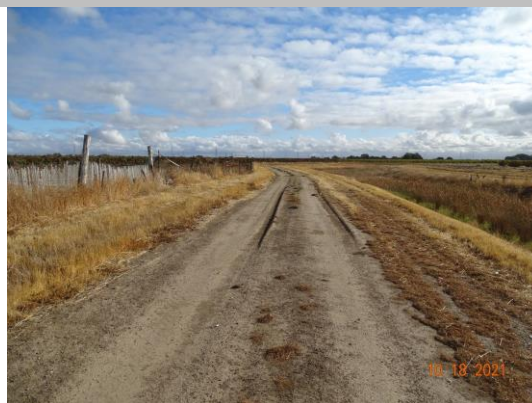
Photo 1 of 1 : FA_2021_NA0017_158_22_20211018_00045.jpg

View of tire ruts with the surface road. Fall 2021

LM Start	0.60	Rating **	M	Issue No.	22
LM End	0.60	Issue Type +	Ma	Location *	CR
Category	Earthen Levee			GPS Latitude/Longitude	
				Start	End
Item	Crown Surface / Depressions / Rutting			38.111733 °	38.111733 °
				-121.150229 °	-121.150229 °
DWR ID	DWR_NA0017_14_f_2020_22				
Comment Code					
C2 : Repair depressions or ruts in the crown or slope.					
Inspector Comment

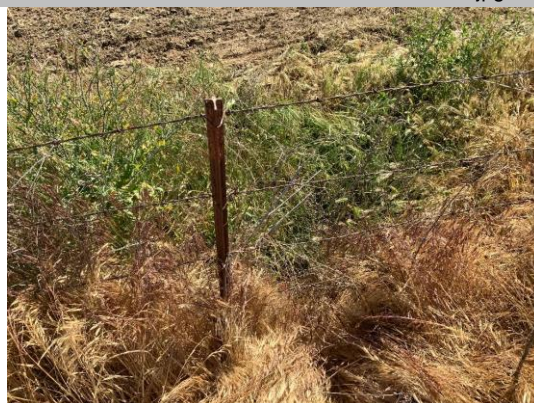
Photo 3 of 3 : UCIP_FA_2021_66878_98444.jpg

Comment Code					
Inspector Comment					
DS_ID:23945 FS_ID:66878 EP_NO: N/A Repair Type: Non-Urgent EVAL Issue: Limited Inspection/No UCIP Evaluation Crossing Status: Found UCIP Comments: 04/29/2021 Pipe status is still Non-Urgent. Unit 14 – Middle Paddle Creek (CLM 0 to 1.38) is considered a patrol road/high ground area with no defined levee prism, any issue found between CLM 0 to 1.38 of Unit 14 will be considered a maintenance issue, or an unauthorized encroachment, or an abandoned encroachment. DWR DMP internal inspection has found pipe integrity issues. LOF of crossing is between 4.1 and 5. Crossing will be monitored until funding becomes available for rehabilitation. Current condition of pipe crossing does not impede access to patrol road/high ground area. Pipe is open on both ends and LS pipe end is covered in vegetation and behind barbed wire, could not inspect. No permit was found authorizing this encroachment. CVFPB will need to review crossing to determine owner. The UCIP inspection was completed with LMA representative, J. Nelson. (H. Dunn – GEI) 06/12/2014 Pipe open on both ends. Levee appears abandoned. (W. Wylie - DWR UCIP) FIELD_STRUCT_DESC: 24-inch corrugated metal drainage pipe through the levee, 1 foot below the crown. Cobble grouted spillway. Cobble grouted intake on the landside (LS). Open on both ends. [Additional Reference(s): DWR Levee Log, 1978. USACE San Joaquin O&M Manual 612.2, 1967, (HLM 0.76)]. FS Date: 4/29/2021

LS view: Pipe inlet covered by vegetation and barbed wire at toe.

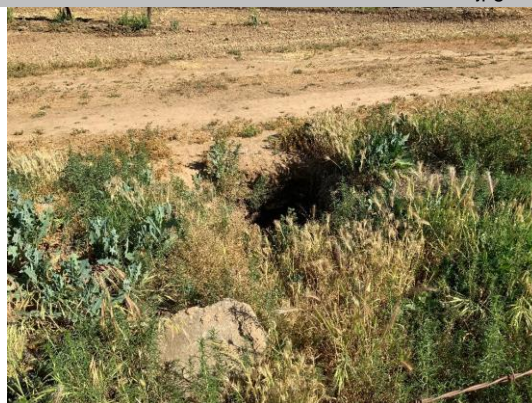
Photo 3 of 3 : UCIP_FA_2021_66879_98449.jpg

Comment Code					
Inspector Comment					
DS_ID:23946 FS_ID:66879 EP_NO: N/A Repair Type: Non-Urgent EVAL Issue: Maintenance Compliance Issue Crossing Status: Found UCIP Comments: 04/29/2021 Pipe status is still Non-Urgent. Unit 14 – Middle Paddle Creek (CLM 0 to 1.38) is considered a patrol road/high ground area with no defined levee prism, any issue found between CLM 0 to 1.38 of Unit 14 will be considered a maintenance issue, or an unauthorized encroachment, or an abandoned encroachment. DWR DMP internal inspection has not found pipe integrity issues. LOF of crossing is less or equal to 4.0. Recommend inspection in 5 years. Current condition of pipe crossing does not impede access to patrol road/high ground area. Pipe is open on both ends, no flapgates and LS pipe end filled with dirt, recommend maintenance for sediment removal. No permit was found authorizing this encroachment. CVFPB will need to review crossing to determine owner. The UCIP inspection was completed with LMA representative, J. Nelson. (H. Dunn – GEI) 06/12/2014 Pipe buried on LS. Levee appears abandoned. (W. Wylie - DWR UCIP) FIELD_STRUCT_DESC: 12-inch corrugated metal drainage pipe through the levee, 2 feet below the crown. Open on both ends. Cobble grouted spillway. [Additional Reference(s): DWR Levee Log, 1978. USACE San Joaquin O&M Manual 612.2, 1967, (HLM 0.95)]. FS Date: 4/29/2021

LS view: Inlet barely visible at toe.

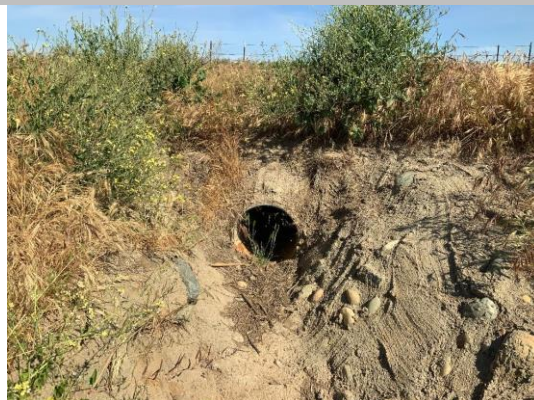
Photo 3 of 3 : UCIP_FA_2021_66883_98456.jpg

DS_ID:23947
FS_ID:66883
EP_NO: N/A
Repair Type: Non-Urgent
EVAL Issue: Pipe Damage
Crossing Status: Found
UCIP Comments: 04/29/2021 Pipe status is still Non-Urgent. Unit 14 – Middle Paddle Creek (CLM 0 to 1.38) is considered a patrol road/high ground area with no defined levee prism, any issue found between CLM 0 to 1.38 of Unit 14 will be considered a maintenance issue, or an unauthorized encroachment, or an abandoned encroachment. DWR DMP internal inspection has found pipe integrity issues. LOF of crossing is between 4.1 and 5. Crossing will be monitored until funding becomes available for rehabilitation. Current condition of pipe crossing does not impede access to patrol road/high ground area. Pipe is open on both ends, no flapgate. No permit was found authorizing this encroachment. CVFPB will need to review crossing to determine owner. The UCIP inspection was completed with LMA representative, J. Nelson. (H. Dunn – GEI) 06/12/2014 Pipe buried on LS shoulder and open on WS. Levee appears abandoned. (W. Wylie - DWR UCIP) FIELD_STRUCT_DESC: *ABANDONED* 18-inch corrugated metal drainage pipe through the levee, 3 feet below the crown. Open on both ends. Cobble grouted spillway. Cobble grouted intake on the landside (LS). [Additional Reference(s): DWR Levee Log, 1978. USACE San Joaquin O&M Manual 612.2, 1967, (HLM 0.97)].

WS view: Slope and pipe outlet at toe.

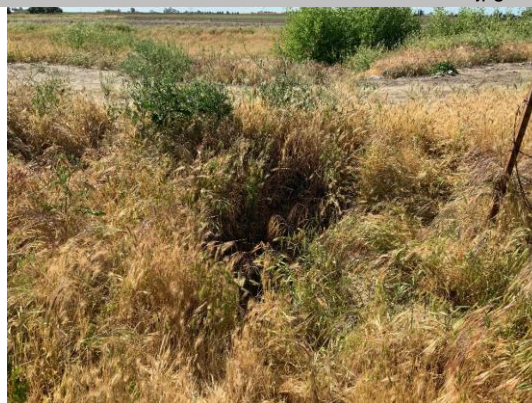
Photo 3 of 3 : UCIP_FA_2021_66888_98470.jpg

Comment Code						
Inspector Comment						
DS_ID:23949 FS_ID:66888 EP_NO: N/A Repair Type: Non-Urgent EVAL Issue: Maintenance Compliance Issue Crossing Status: Found UCIP Comments: 04/29/2021 Pipe status is still Non-Urgent. Unit 14 – Middle Paddle Creek (CLM 0 to 1.38) is considered a patrol road/high ground area with no defined levee prism, any issue found between CLM 0 to 1.38 of Unit 14 will be considered a maintenance issue, or an unauthorized encroachment, or an abandoned encroachment. DWR DMP internal inspection has not found pipe integrity issues. LOF of crossing is less or equal to 4.0. Recommend inspection in 5 years. Current condition of pipe crossing does not impede access to patrol road/high ground area. LS and WS pipe inlet and flapgate covered with vegetation, recommend removal. No permit was found authorizing this encroachment. CVFPB will need to review crossing to determine owner. The UCIP inspection was completed with LMA representative, J. Nelson. (H. Dunn – GEI) 06/12/2014 Pipe appears abandoned. Levee appears Abandoned. (W. Wylie - DWR UCIP) FIELD_STRUCT_DESC: *ABANDONED* 12-inch corrugated metal drainage pipe through the levee, 2.5 feet below the crown. Flap gate on the waterside (WS) end. Cobble grouted spillway. Cobble grouted intake on the landside (LS). [Additional Reference(s): DWR Levee Log, 1978. USACE San Joaquin O&M Manual 612.2, 1967, (HLM 1.12)]. FS Date: 4/29/2021

LS view: Pipe inlet covered by vegetation at toe.

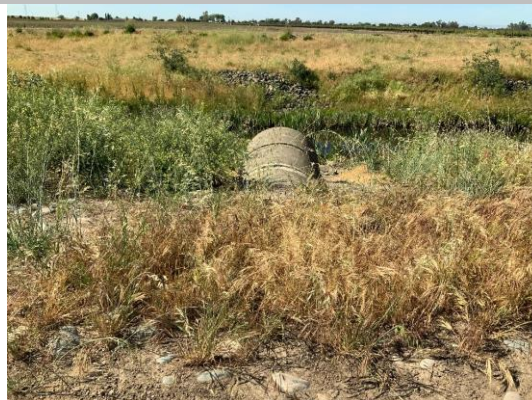
Photo 2 of 3 : UCIP_FA_2021_66889_98477.jpg

Comment Code					
Inspector Comment					
DS_ID:23950 FS_ID:66889 EP_NO: N/A Repair Type: Non-Urgent EVAL Issue: Maintenance Compliance Issue Crossing Status: Found UCIP Comments: 04/29/2021 Pipe status is still Non-Urgent. Unit 14 – Middle Paddle Creek (CLM 0 to 1.38) is considered a patrol road/high ground area with no defined levee prism, any issue found between CLM 0 to 1.38 of Unit 14 will be considered a maintenance issue, or an unauthorized encroachment, or an abandoned encroachment. DWR DMP internal inspection has not found pipe integrity issues. LOF of crossing is less or equal to 4.0. Recommend inspection in 5 years. Current condition of pipe crossing does not impede access to patrol road/high ground area. Pipe is open on both ends, no flapgate. No permit was found authorizing this encroachment. CVFPB will need to review crossing to determine owner. The UCIP inspection was completed with LMA representative, J. Nelson. (H. Dunn – GEI) 06/12/2014 Pipe open on both ends. Levee appears abandoned. (W. Wylie - DWR UCIP) FIELD_STRUCT_DESC: 48-inch reinforced concrete drainage pipe through the levee, 5.5 feet below the crown. Cobble grouted spillway. Cobble grouted intake on the landside (LS). Open on both ends. [Additional Reference(s): DWR Levee Log, 1978. USACE San Joaquin O&M Manual 612.2, 1967, (HLM 1.17)]. FS Date: 4/29/2021

WS view: Pipe visible at toe from crown.

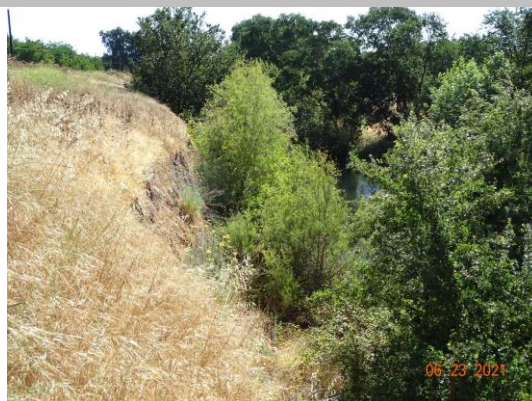
Photo 1 of 3 : SJR2021_NA0017U15RM22.91_1.JPG

Comment Code						
Inspector Comment						
Site ID: NA0017U15RM22.91						
06/23/2021: The erosion length was updated to 820 ft based on more accurate field measurements. Otherwise, no significant changes were observed since the previous inspection.						
07/23/2020: New erosion visible in some locations. The area is densely vegetated.						
08/28/2019: From 2011 to 2019, no significant changes were observed during the annual survey.						
11/02/2010: The mile-long erosion continues to degrade the bank. There are a few trees along the mile-long stretch on the lower bank slope that are affected by the scarp. WS Levee Slope was changed to 2:1. As a result, normalized score increased from 62 to 65.						
08/05/2010: Recommended for waterside repair, per CLRO; "water velocity is a major factor for accelerating bank slope erosion."						
8/12/2009: Near-vertical bank erosion; degrading channel is incising the banks; recommend annual assessment and monitoring of critical erosion site, per CLRO CES Evaluation 2008 Report; district is monitoring site for change in condition; site was previously rated "U".

2007: Visited site 02/06/2007; possible critical site.

6/23/2021: View of the erosion looking upstream.

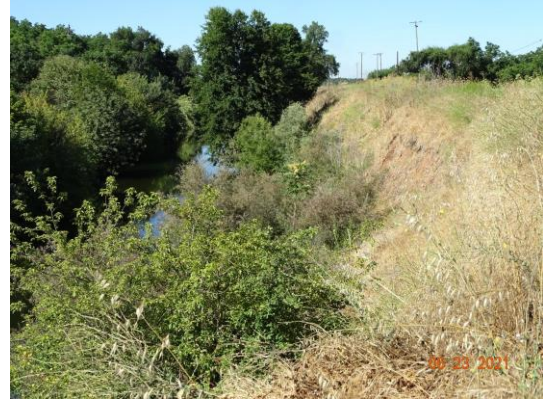
Photo 2 of 3 : SJR2021_NA0017U15RM22.91_2.JPG

6/23/2021: View of the erosion looking downstream.

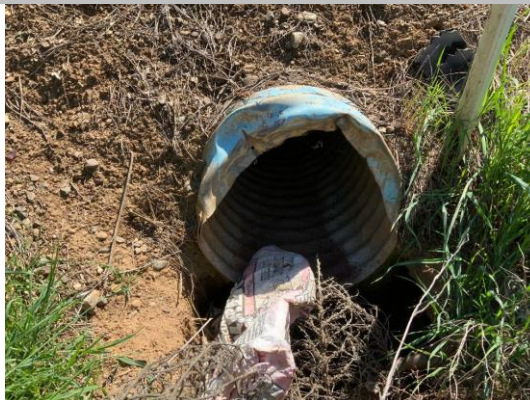
Photo 2 of 3 : UCIP_FA_2021_66898_93985.jpg

Comment Code						
Inspector Comment						
DS_ID:23199 FS_ID:66898 EP_NO: N/A Repair Type: Non-Urgent EVAL Issue: Maintenance Compliance Issue Crossing Status: Found UCIP Comments: 03/26/2021 Record has been upgraded from No Action Needed to Non-Urgent. Unit 15 – Mormon Slough (CLM 0 to 1.50 and 5.0 - 11.0) are considered a patrol road/high ground area with no defined levee prism, any issue found between CLM 0 - 1.50 and 5.0 – 11.0 of Unit 15 will be considered a maintenance issue, or an unauthorized encroachment, or an abandoned encroachment. DWR DMP internal video inspection has found pipe integrity issues. LOF of crossing is between 5 and 6. Crossing will be monitored until funding becomes available to address the issues. Current condition of pipe crossing does not impede access to patrol road/high ground area. No permit was found authorizing this encroachment. CVFPB will need to review crossing to determine owner. The UCIP inspection was completed with LMA representative, H. Latu. (H. Dunn – GEI) 04/09/2014 Deformed inlet opening. Needs cleaning and clearing on inlet opening on landside. (P. Tariq - DWR UCIP) FIELD_STRUCT_DESC: 18-inch corrugated metal drainage pipe through the levee, 4.5 feet below the crown. Grouted spillway on the waterside (WS) end. Open on both ends. [Additional Reference(s): DWR Levee Log, 1992. USACE San Joaquin O&M Manual 611.1, Volume F, (HLM 1.18)]. FS Date: 3/26/2021

LS view: Inside pipe inlet.

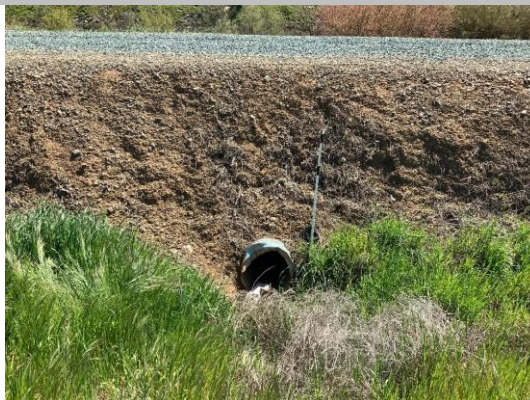
Photo 3 of 3 : UCIP_FA_2021_66898_93984.jpg

LS view: Pipe end at toe.

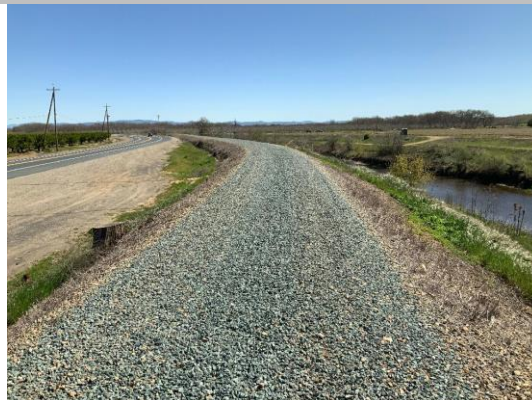
Photo 1 of 3 : UCIP_FA_2021_66899_93996.jpg

Comment Code						
Inspector Comment						
DS_ID:23200 FS_ID:66899 EP_NO: N/A Repair Type: Non-Urgent EVAL Issue: Maintenance Compliance Issue Crossing Status: Found UCIP Comments: 03/26/2021 Record has been upgraded from No Action Needed to Non-Urgent. Unit 15 – Mormon Slough (CLM 0 to 1.50 and 5.0 - 11.0) are considered a patrol road/high ground area with no defined levee prism, any issue found between CLM 0 - 1.50 and 5.0 – 11.0 of Unit 15 will be considered a maintenance issue, or an unauthorized encroachment, or an abandoned encroachment. DWR DMP internal video inspection has found pipe integrity issues. LOF of crossing is between 5 and 6. Crossing will be monitored until funding becomes available to address the issues. Recommend cleaning dirt/vegetation debris off/out of LS pipe end. Current condition of pipe crossing does not impede access to patrol road/high ground area. No permit was found authorizing this encroachment. CVFPB will need to review crossing to determine owner. The UCIP inspection was completed with LMA representative, H. Latu. (H. Dunn – GEI) 04/09/2021 Pipe needs cleaning and clearing on both pipe ends. (P. Tariq - DWR UCIP) FIELD_STRUCT_DESC: 18-inch drainage pipe of an unknown material through the levee, 6 feet below the crown. Grouted spillway on the waterside (WS) end. Electrical conduit through the levee. [Additional Reference(s): DWR Levee Log, 1992. USACE San Joaquin O&M Manual 611.1, Volume F, (HLM 1.49)]. FS Date: 3/26/2021

Levee crown looking upstream.

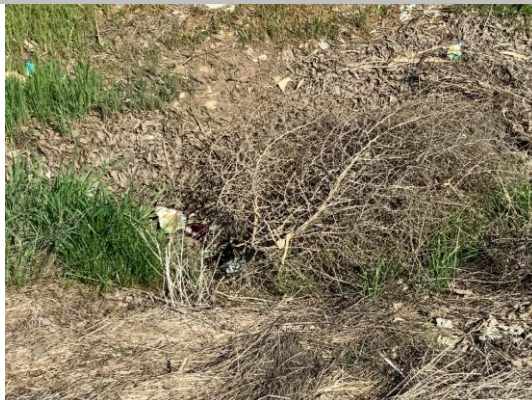
Photo 2 of 3 : UCIP_FA_2021_66899_94001.jpg

LM Start	1.46	Rating **	M	Issue No.	1160 (cont)
LM End	1.46	Issue Type +	Ma	Location *	
Category	Supplemental			GPS Latitude/Longitude	
				Start	End
Item	DWR UCIP LMA Responsibility			38.040197 °	38.040197 °
				-121.032044 °	-121.032044 °
DWR ID	23200

LS view: Pipe end covered in vegetation and dirt.

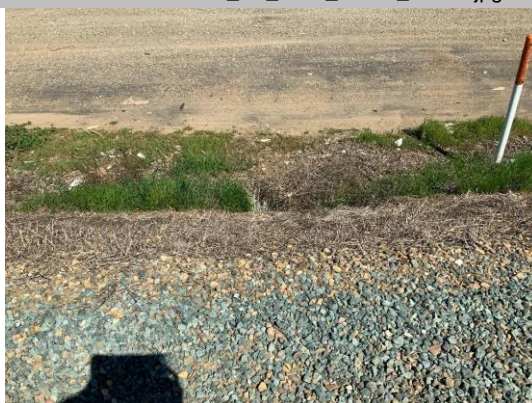
Photo 3 of 3 : UCIP_FA_2021_66899_94000.jpg

LS view: Toe from crown.

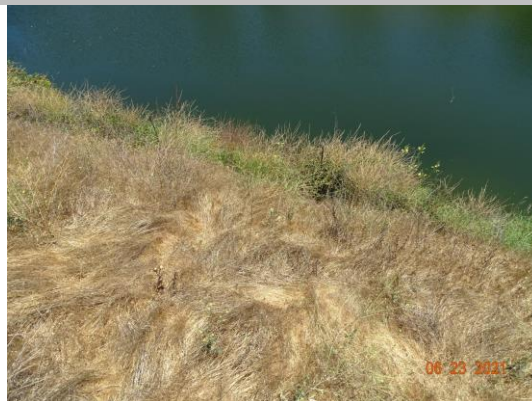
Photo 1 of 1 : SJR2021_NA0017U15RM18.45_1.JPG

LM Start	4.51	Rating **	M	Issue No.	14
LM End	4.52	Issue Type +	Ma	Location *	
Category	Supplemental			GPS Latitude/Longitude	
				Start	End
Item	DWR Erosion Survey			38.009753 °	38.009753 °
				-121.069559 °	-121.069559 °
DWR ID	NA0017U15RM18.45				
Comment Code					
Inspector Comment					
Site ID: NA0017U15RM18.45					
06/23/2021: No significant changes were observed since the previous inspection.					
07/23/2020: This site was discovered during the DWR Fall 2015 Levee Inspections. Although dense vegetation is limiting the view, the erosion, which extends to the upper levee slope, could still be seen.

6/23/2021: Looking down the levee slope. Dense vegetation is limiting the view of the erosion.

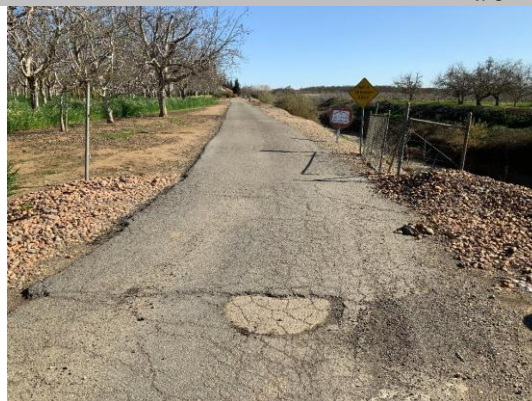
Photo 1 of 3 : UCIP_FA_2021_66920_94206.jpg

DS_ID:23308
FS_ID:66920
EP_NO: N/A
Repair Type: Non-Urgent
EVAL Issue: Maintenance Compliance Issue
Crossing Status: Found
UCIP Comments: 03/26/2021 Record has been upgraded from No Action Needed to Non-Urgent. Unit 15 – Mormon Slough (CLM 0 to 1.50 and 5.0 - 11.0) are considered a patrol road/high ground area with no defined levee prism, any issue found between CLM 0 - 1.50 and 5.0 – 11.0 of Unit 15 will be considered a maintenance issue, or an unauthorized encroachment, or an abandoned encroachment.
03/26/2021 Record has been upgraded from No Action Needed to Non-Urgent. Unit 15 – Mormon Slough (CLM 0 to 1.50 and 5.0 - 11.0) are considered a patrol road/high ground area with no defined levee prism, any issue found between CLM 0 - 1.50 and 5.0 – 11.0 of Unit 15 will be considered a maintenance issue, or an unauthorized encroachment, or an abandoned encroachment. DWR DMP internal video inspection has found pipe integrity issues. LOF of crossing is between 5 and 6. Crossing will be monitored until funding becomes available to address the issues. Current condition of pipe crossing does not impede access to patrol road/high ground area. No permit was found authorizing this encroachment. CVFPB will need to review crossing to determine owner. The UCIP inspection was completed with LMA representative, H. Latu. (H. Dunn – GEI) 04/09/2014 Inlet CM pipe riser on landside shoulder. Pipe not found on waterside. Dense vegetation on channel bank. May need inlet cleaning. (P. Tariq - DWR UCIP)

FIELD_STRUCT_DESC: 18-inch corrugated metal drainage pipe, 2 feet below the roadway. Concrete rubble splash apron on the waterside (WS) end. [Additional Reference(s): DWR Levee Log, 1977. USACE San Joaquin O&M Manual 611.1, Volume F, (HLM 5.58)].
FS Date: 3/26/2021

Levee crown looking upstream.

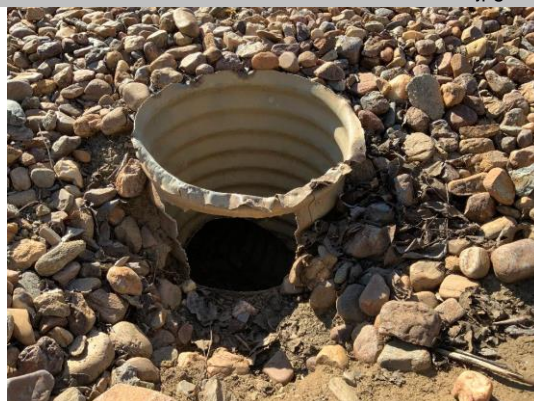
Photo 2 of 3 : UCIP_FA_2021_66920_94209.jpg

LM Start	5.46	Rating **	M	Issue No.	1174 (cont)
LM End	5.46	Issue Type +	Ma	Location *	
Category	Supplemental		GPS Latitude/Longitude		
			Start	End	
Item	DWR UCIP LMA Responsibility		37.997990 °	37.997990 °	
			-121.078092 °	-121.078092 °	
DWR ID	23308

LS view: Metal riser at toe is bent and warped.

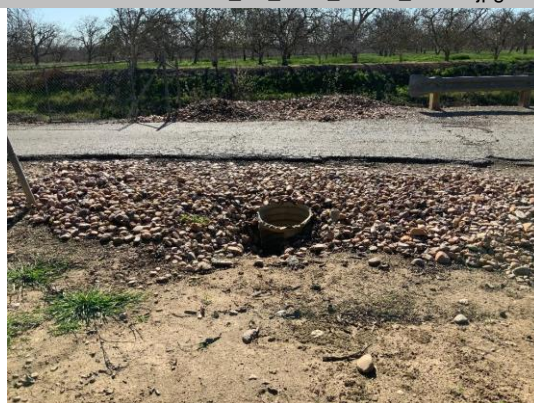
Photo 3 of 3 : UCIP_FA_2021_66920_94208.jpg

LS view: Metal riser at toe.

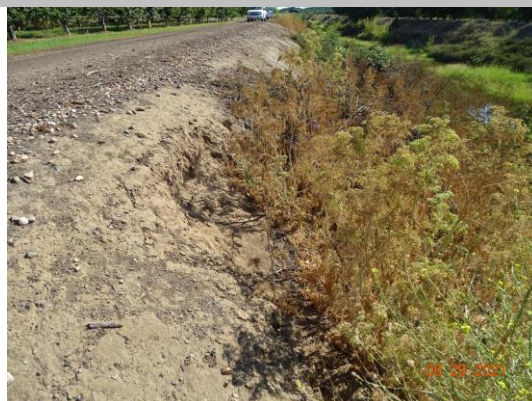
Photo 1 of 2 : SJR2021_NA0017U15RM17.67_1.JPG

*This area is patrol road only and therefore the site is not rated
06/29/2021: There is more vegetation on the slope. Otherwise, no significant changes were observed since the previous inspection.
07/24/2020: Some burrowing activity observed. Site is likely to extend toward downstream during the next rain event.
08/28/2019: The erosion is located at the upper slope of the channel bank and was likely caused by rainfall runoff.

6/29/2021: View of the erosion looking upstream.

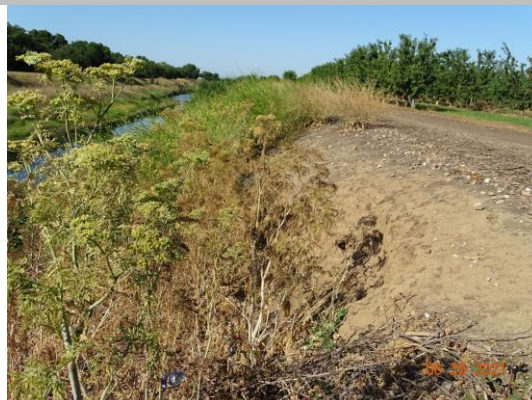
Photo 2 of 2 : SJR2021_NA0017U15RM17.67_3.JPG

6/29/2021: View of the erosion looking downstream.

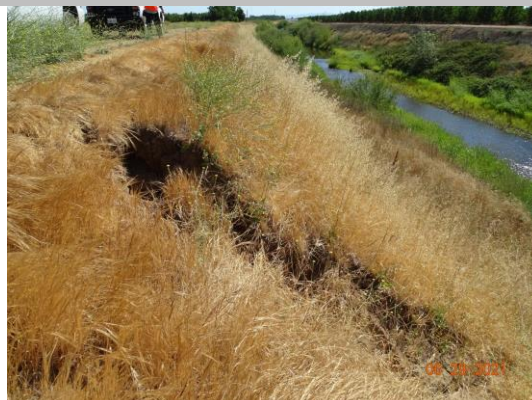
Photo 2 of 2 : SJR2021_NA0017U15RM15.25_3.JPG

6/29/2021: Close-up view of the erosion.

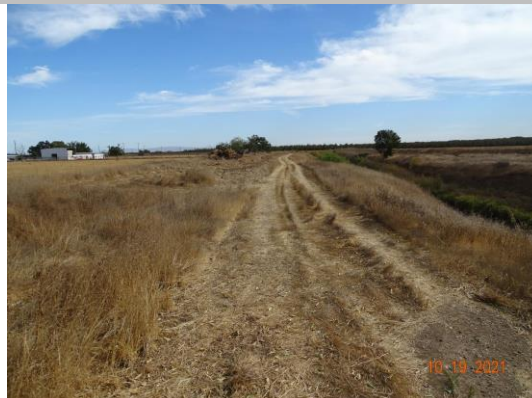
Photo 1 of 1 : FA_2021_NA0017_159_184_20211019_00517.jpg

LM Start	8.08	Rating **	M	Issue No.	184
LM End	8.47	Issue Type +	Ma	Location *	CR
Category	Earthen Levee		GPS Latitude/Longitude		
			Start	End	
Item	Vegetation		37.972784 °	37.969649 °	
			-121.112523 °	-121.117543 °	
DWR ID	DWR_NA0017_15_s_2021_184				
Comment Code					
V9 : Keep the crown roadway free of vegetation.					
Inspector Comment

View of vegetation covering crown and surface road. Fall 2021

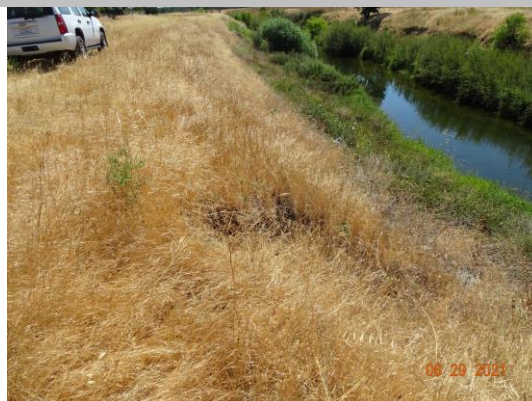
Photo 1 of 1 : SJR2021_NA0017U15RM14.49_2.JPG

LM Start	8.43	Rating **	A/W	Issue No.	5	
LM End	8.44	Issue Type +	Ma	Location *		
Category	Supplemental			GPS Latitude/Longitude		
				Start		End
Item	DWR Erosion Survey			37.969711 °		37.969711 °
				-121.116739 °		-121.116739 °
DWR ID	NA0017U15RM14.49					
Comment Code						
Inspector Comment						
Site ID: NA0017U15RM14.49						
*This area is patrol road only and therefore the site is not rated						
06/29/2021: From 2014 to present, no significant changes were						
observed during the annual survey. There are signs of animal activity.						
09/12/2013: The erosion has been caused by runoff.

6/29/2021: View of the erosion looking upstream

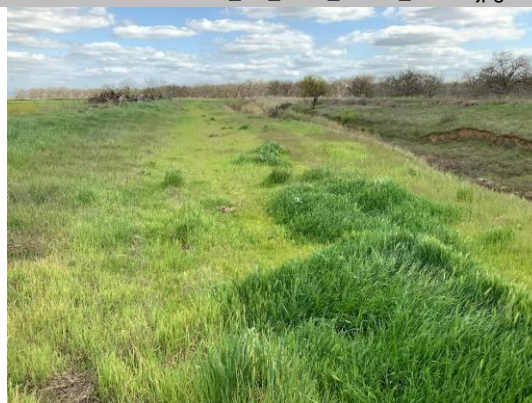
Photo 1 of 3 : UCIP_FA_2021_65489_94355.jpg

Comment Code						
Inspector Comment						
DS_ID:23227						
FS_ID:65489						
EP_NO: N/A						
Repair Type: Non-Urgent						
EVAL Issue: Maintenance Compliance Issue						
Crossing Status: Found						
UCIP Comments: 03/25/2021 Pipe status is still Non-Urgent. Unit 15 – Mormon Slough (CLM 0 to 1.50 and 5.0 - 11.0) are considered a patrol road/high ground area with no defined levee prism, any issue found between CLM 0 - 1.50 and 5.0 – 11.0 of Unit 15 will be considered a maintenance issue, or an unauthorized encroachment, or an abandoned encroachment. LS pipe end covered in dirt and veegestation, recommend cleaning out. Cannot see WS pipe end. Current condition of pipe crossing does not impede access to patrol road/high ground area. No permit was found authorizing this encroachment. CVFPB will need to review crossing to determine owner. The UCIP inspection was completed with LMA representative, H. Latu. (H. Dunn – GEI)

04/10/2014 Distorted inlet pipe opening on landside. No pipe found on waterside. Dense vegetation and steep slope on waterside. (P. Tariq - DWR UCIP)						
FIELD_STRUCT_DESC: 18-inch CM pipe through the levee, 1.0 feet below the crown. O&M Manual SJR Assumed 999.						
FS Date: 3/25/2021

Levee crown looking upstream.

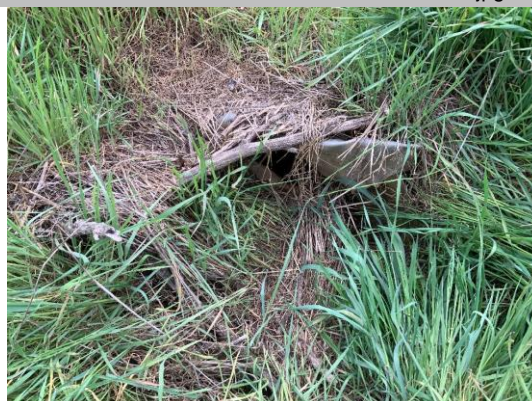
Photo 2 of 3 : UCIP_FA_2021_65489_94357.jpg

LS view: Pipe end covered in dirt and vegetation at toe.

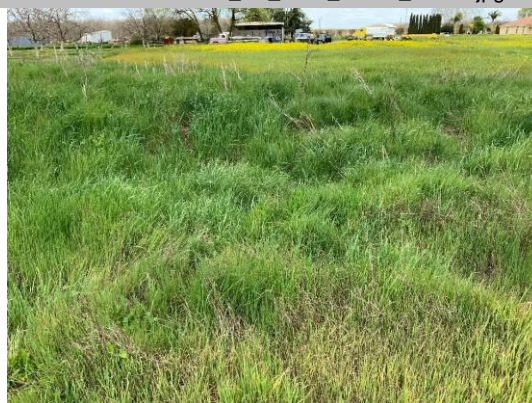
Photo 3 of 3 : UCIP_FA_2021_65489_94356.jpg

LS view: Toe from crown, pipe not visible.

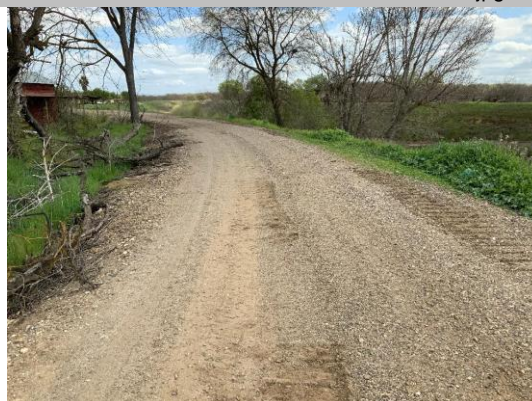
Photo 1 of 3 : UCIP_FA_2021_66938_94363.jpg

Comment Code						
Inspector Comment						
DS_ID:23229 FS_ID:66938 EP_NO: N/A Repair Type: Non-Urgent EVAL Issue: Maintenance Compliance Issue Crossing Status: Found UCIP Comments: 03/25/2021 Pipe status is still Non-Urgent. Unit 15 – Mormon Slough (CLM 0 to 1.50 and 5.0 - 11.0) are considered a patrol road/high ground area with no defined levee prism, any issue found between CLM 0 - 1.50 and 5.0 – 11.0 of Unit 15 will be considered a maintenance issue, or an unauthorized encroachment, or an abandoned encroachment. LS pipe end bent and warped and covered with debris, recommend clearing away. Cannot see WS pipe end. Current condition of pipe crossing does not impede access to patrol road/high ground area. No permit was found authorizing this encroachment. CVFPB will need to review crossing to determine owner. The UCIP inspection was completed with LMA representative, H. Latu. (H. Dunn – GEI) 04/10/2014 Distorted pipe opening on landside. Inlet pipe needs clearing and cleaning. (P. Tariq - DWR UCIP)No pipe visible on waterside. FIELD_STRUCT_DESC: 18-inch corrugated metal drainage pipe and electrical conduit of an unknown material through the levee, 1 foot below the crown. Power pole on the landside (LS). Electrical conduit through the levee. Outlet of pipe rock revetted. [Additional Reference(s): DWR Levee Log, 1992. USACE San Joaquin O&M Manual 611.1, Volume F, (HLM 8.88)]. FS Date: 3/25/2021

Levee crown looking upstream.

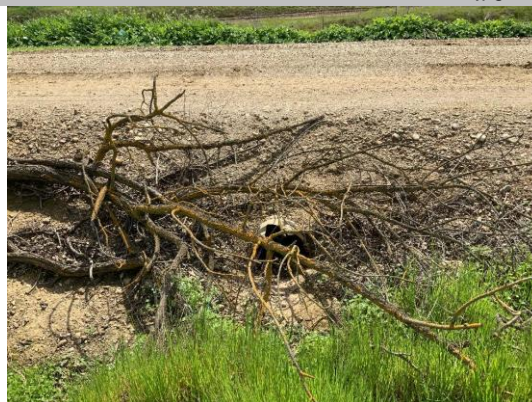
Photo 2 of 3 : UCIP_FA_2021_66938_94365.jpg

LS view: Pipe end visible at toe.

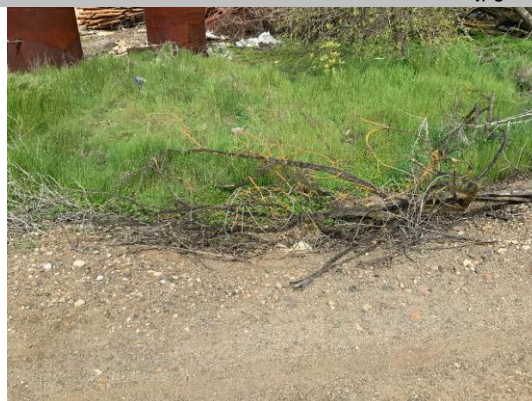
Photo 3 of 3 : UCIP_FA_2021_66938_94364.jpg

LS view: Toe from crown.

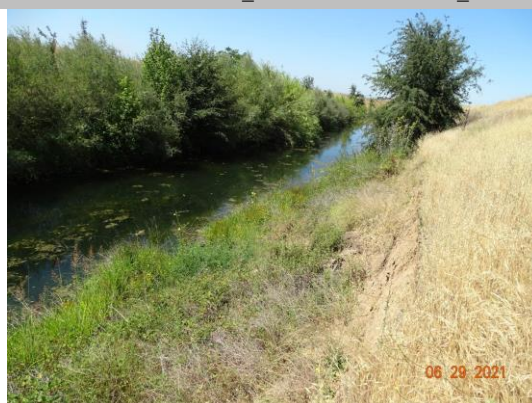
Photo 1 of 2 : SJR2021_NA0017U15RM13.87_3.JPG

*This area is patrol road only and therefore the site is not rated
06/29/2021: From 2015 to present, no significant changes were observed during the annual survey.

6/29/2021: View of the erosion looking downstream.

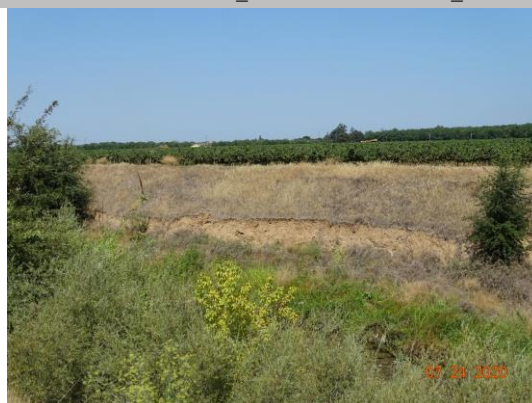
Photo 2 of 2 : SJR2021_NA0017U15RM13.87_02.JPG

7/24/2020: View of the erosion from the opposite bank.

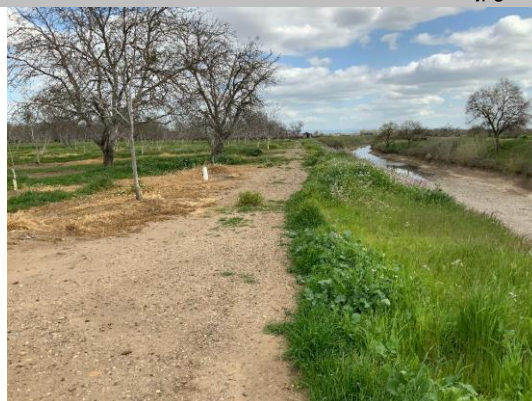
Photo 1 of 3 : UCIP_FA_2021_66952_94407.jpg

Comment Code						
Inspector Comment						
DS_ID:23233 FS_ID:66952 EP_NO: N/A Repair Type: Non-Urgent EVAL Issue: Maintenance Compliance Issue Crossing Status: Found UCIP Comments: 03/25/2021 Pipe status is still Non-Urgent. Unit 15 - Mormon Slough (CLM 0 to 1.50 and 5.0 - 11.0) are considered a patrol road/high ground area with no defined levee prism, any issue found between CLM 0 - 1.50 and 5.0 - 11.0 of Unit 15 will be considered a maintenance issue, or an unauthorized encroachment, or an abandoned encroachment. DWR DMP internal video inspection has found pipe integrity issues. LOF of crossing is between 4.1 and 5. Crossing will be monitored until funding becomes available for rehabilitation. LS pipe buried under dirt and vegetation with some dirt seen inside WS pipe, recommend cleaning out both sides. Current condition of pipe crossing does not impede access to patrol road/high ground area. No permit was found authorizing this encroachment. CVFPB will need to review crossing to determine owner. The UCIP inspection was completed with LMA representative, H. Latu. (H. Dunn - GEI) 04/10/2014 Needs clearing and cleaning of the pipe. (P. Tariq - DWR UCIP) FIELD_STRUCT_DESC: 18-inch corrugated metal drainage pipe through the levee, 3.5 feet below the crown. Pipe discharges onto waterside (WS) slope. Slope eroding. [Additional Reference(s): DWR Levee Log, 1992. USACE San Joaquin O&M Manual 611.1, Volume F, (HLM 9.75)]. FS Date: 3/25/2021

Levee crown looking upstream.
