**Flood Control Project Maintenance
Levee Inspections**

Maintenance Issue Types Only, Levee Inspection Report By Mile - Fall 2021

San Joaquin County Flood Control and Water Conservation District

Waterway	Bank	Unit Miles	Inspection Start/End	Inspector
Unit No. 01 Littlejohn Creek	Left	2.59	10/21/2021 10/21/2021	Alberto De Leon

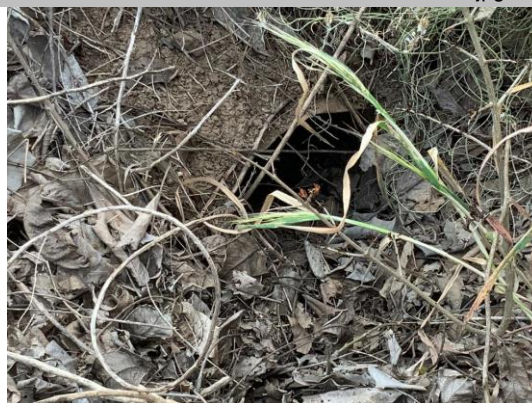
Photo 2 of 3 : UCIP_FA_2021_66952_94409.jpg

LS view: Pipe inlet covered in dirt and vegetation.

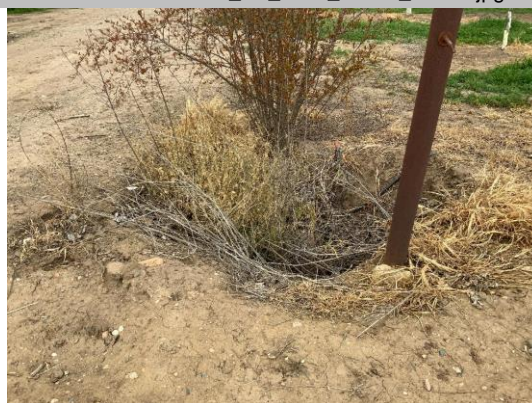
Photo 3 of 3 : UCIP_FA_2021_66952_94408.jpg

LS view: Toe from crown.

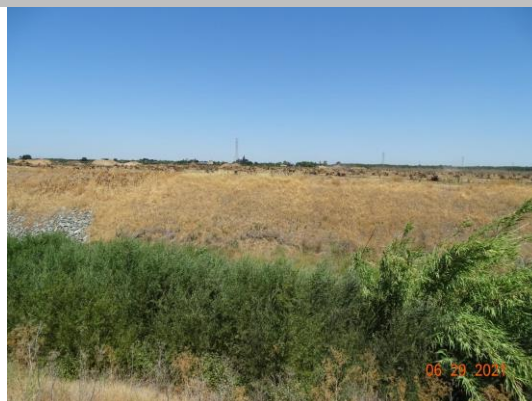
Photo 1 of 3 : SJR2021_NA0017U15RM13.25_2.JPG

LM Start	9.61	Rating **	A/W	Issue No.	11	
LM End	9.63	Issue Type +	Ma	Location *		
Category	Supplemental			GPS Latitude/Longitude		
				Start		End
Item	DWR Erosion Survey			37.965693 °		37.965693 °
				-121.137063 °		-121.137063 °
DWR ID	NA0017U15RM13.25					
Comment Code						
Inspector Comment						
Site ID: NA0017U15RM13.25 *This area is patrol road only and therefore the site is not rated 06/29/2021: The upper slope is now covered with vegetation. The erosion scarp on the lower slope is clearly visible. 07/24/2020: The erosion site has been repaired by placing fill and riprap. A new erosion site was discovered just downstream of this site (see Site ID NA0017U15RM13.22). 08/28/2019: The erosion is located at the lower slope of the channel bank and covered by dense vegetation.

6/29/2021: View of the erosion from the opposite bank.

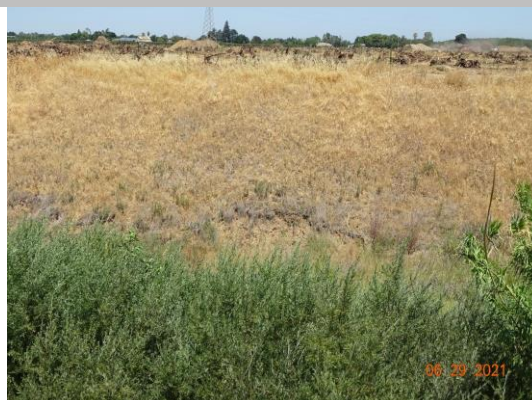
Photo 2 of 3 : SJR2021_NA0017U15RM13.25_3.JPG

6/29/2021: Close-up view of the erosion.

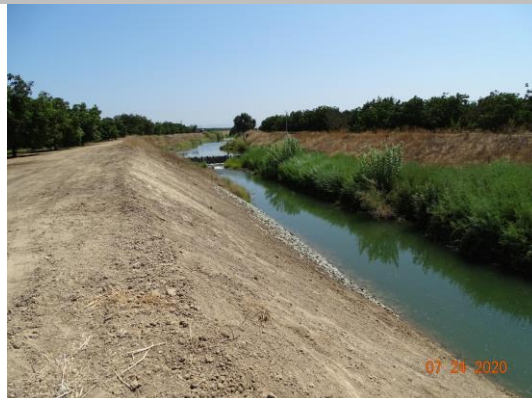
Photo 3 of 3 : SJR2021_NA0017U15RM13.25_01.JPG

7/24/2020: View of the repaired erosion site looking upstream.

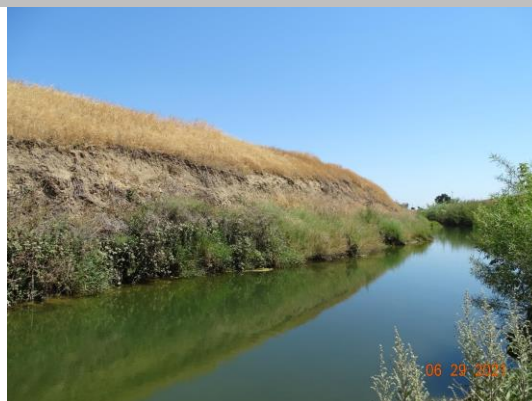
Photo 1 of 3 : SJR2021_NA0017U15RM13.22_5.JPG

07/24/2020: The site was discovered during the field survey. The erosion is immediately downstream of a newly repaired erosion site (NA0017U15RM13.25). The erosion begins at the shoulder and extends down the entire slope. Some sloughing is visible on the upper slope and the stream has cut into the bank.

6/29/2021: View of the erosion from the opposite bank looking upstream.

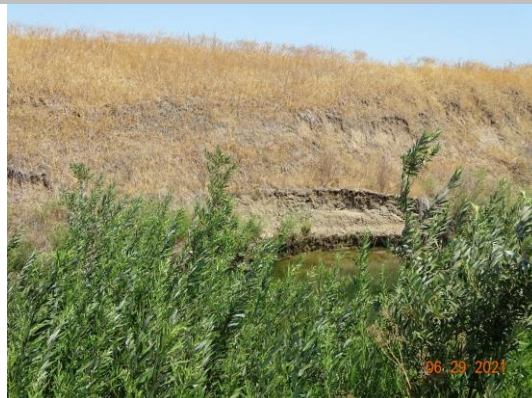
Photo 2 of 3 : SJR2021_NA0017U15RM13.22_4.JPG

6/29/2021: Close-up view of the erosion.

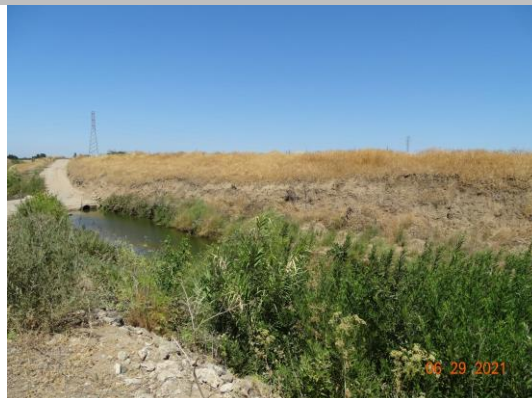
Photo 3 of 3 : SJR2021_NA0017U15RM13.22_2.JPG

6/29/2021: View of the downstream end of the erosion and the ford.

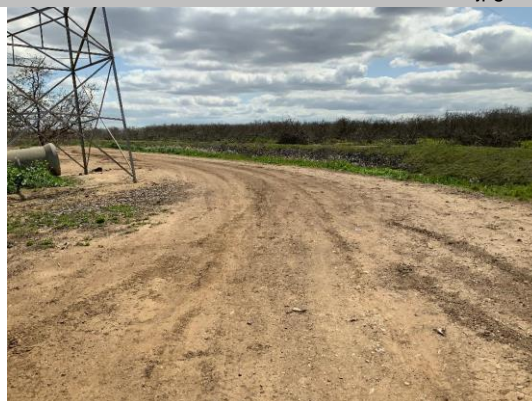
Photo 1 of 3 : UCIP_FA_2021_66955_94427.jpg

Comment Code						
Inspector Comment						
DS_ID:23235 FS_ID:66955 EP_NO: N/A Repair Type: Non-Urgent EVAL Issue: Maintenance Compliance Issue Crossing Status: Found UCIP Comments: 03/25/2021 Pipe status is still Non-Urgent. Unit 15 - Mormon Slough (CLM 0 to 1.50 and 5.0 - 11.0) are considered a patrol road/high ground area with no defined levee prism, any issue found between CLM 0 - 1.50 and 5.0 - 11.0 of Unit 15 will be considered a maintenance issue, or an unauthorized encroachment, or an abandoned encroachment. LS pipe has some debris piled up, recommend cleaning out. DWR DMP internal video inspection has found pipe integrity issues. LOF of crossing is between 4.1 and 5. Crossing will be monitored until funding becomes available for rehabilitation. Current condition of pipe crossing does not impede access to patrol road/high ground area. No permit was found authorizing this encroachment. CVFPB will need to review crossing to determine owner. The UCIP inspection was completed with LMA representative, H. Latu. (H. Dunn - GEI) 04/10/2014 Mud/soil in inlet pipe. Needs cleaning. (P. Tariq - DWR UCIP)No pipe or appurtenances visible on waterside. Dense vegetation (may be visible from other channel bank). FIELD_STRUCT_DESC: 18-inch corrugated metal drainage pipe through the levee, 4 feet below the crown. Grouted inlet and outlet. [Additional Reference(s): DWR Levee Log, 1992. USACE San Joaquin O&M Manual 611.1, Volume F, (HLM 10.01)]. FS Date: 3/25/2021

Levee crown looking upstream.

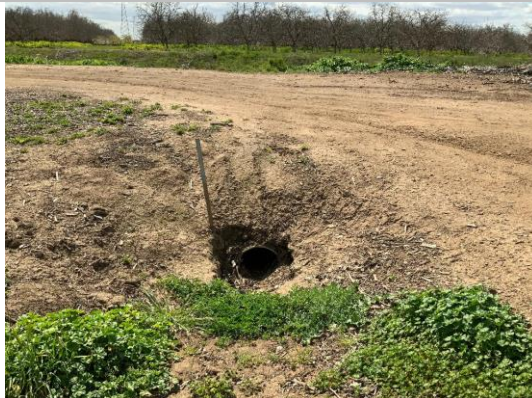
Photo 2 of 3 : UCIP_FA_2021_66955_94429.jpg

LS view: Inlet visible at toe.

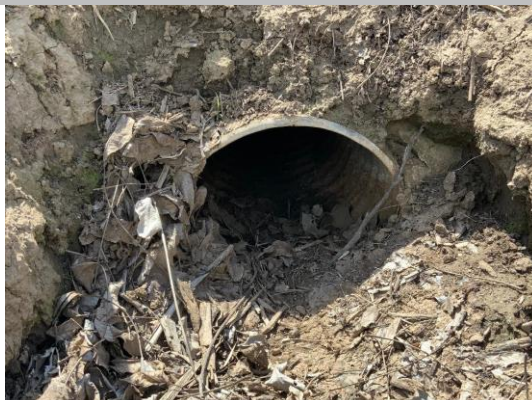
Photo 3 of 3 : UCIP_FA_2021_66955_94430.jpg

LS view: Pipe covered with debris.

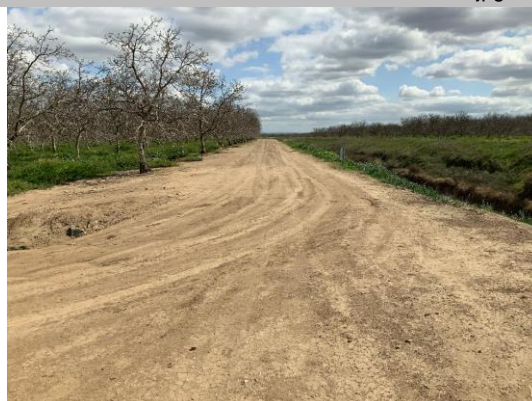
Photo 1 of 3 : UCIP_FA_2021_66956_94436.jpg

Comment Code						
Inspector Comment						
DS_ID:23236 FS_ID:66956 EP_NO: N/A Repair Type: Non-Urgent EVAL Issue: Maintenance Compliance Issue Crossing Status: Found UCIP Comments: 03/25/2021 Pipe status is still Non-Urgent. Unit 15 - Mormon Slough (CLM 0 to 1.50 and 5.0 - 11.0) are considered a patrol road/high ground area with no defined levee prism, any issue found between CLM 0 - 1.50 and 5.0 - 11.0 of Unit 15 will be considered a maintenance issue, or an unauthorized encroachment, or an abandoned encroachment. LS pipe end filled with debris and dirt, recommend cleaning out. WS pipe end not seen. DWR DMP internal video inspection has not found pipe integrity issues. LOF of crossing is less or equal to 4.0. Recommend next video inspection in 5 years. Current condition of pipe crossing does not impede access to patrol road/high ground area. No permit was found authorizing this encroachment. CVFPB will need to review crossing to determine owner. The UCIP inspection was completed with LMA representative, H. Latu. (H. Dunn - GEI) 04/10/2014 May need cleaning of the pipe. (P. Tariq - DWR UCIP)Pipe not visible on waterside. FIELD_STRUCT_DESC: 18-inch corrugated metal drainage pipe through the levee, 4.5 feet below the crown. Grouted inlet and outlet. [Additional Reference(s): DWR Levee Log, 1992. USACE San Joaquin O&M Manual 611.1, Volume F, (HLM 10.22)]. FS Date: 3/25/2021

Levee crown looking upstream.

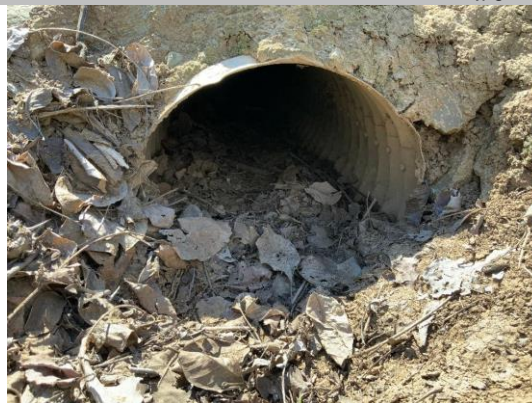
Photo 2 of 3 : UCIP_FA_2021_66956_94439.jpg

LS view: Pipe end filled with debris.

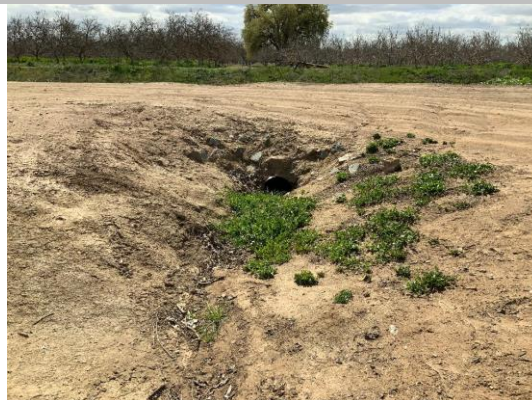
Photo 3 of 3 : UCIP_FA_2021_66956_94438.jpg

LS view: Pipe inlet visible at toe.

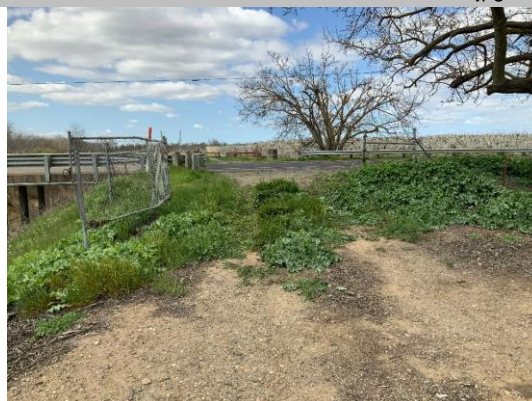
Photo 1 of 3 : UCIP_FA_2021_66959_94453.jpg

Comment Code						
Inspector Comment						
DS_ID:23237 FS_ID:66959 EP_NO: N/A Repair Type: Non-Urgent EVAL Issue: Maintenance Compliance Issue Crossing Status: Found UCIP Comments: 03/25/2021 Record has been issued upgraded from No Action Needed to Non-Urgent. Unit 15 – Mormon Slough (CLM 0 to 1.50 and 5.0 - 11.0) are considered a patrol road/high ground area with no defined levee prism, any issue found between CLM 0 - 1.50 and 5.0 – 11.0 of Unit 15 will be considered a maintenance issue, or an unauthorized encroachment, or an abandoned encroachment. DWR DMP internal video inspection has found pipe integrity issues. LOF of crossing is between 4.1 and 5. Crossing will be monitored until funding becomes available for rehabilitation. Current condition of pipe crossing does not impede access to patrol road/high ground area. No permit was found authorizing this encroachment. CVFPB will need to review crossing to determine owner. The UCIP inspection was completed with LMA representative, H. Latu. (H. Dunn – GEI) 04/10/2014 May need cleaning of the inlet pipe. Vegetation debris on inlet box. (P. Tariq - DWR UCIP) FIELD_STRUCT_DESC: 18-inch corrugated metal drainage pipe through the levee, 7.5 feet below the crown. Concrete U-shaped headwall on the landside (LS). Flap gate on the waterside (WS). [Additional Reference(s): DWR Levee Log, 1992. USACE San Joaquin O&M Manual 611.1, Volume F, (HLM 10.47)]. FS Date: 3/25/2021

Levee crown looking downstream.

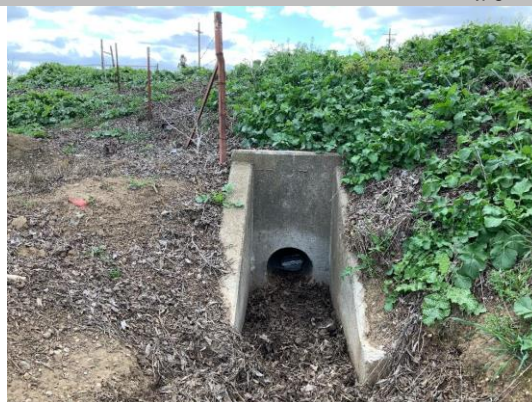
Photo 2 of 3 : UCIP_FA_2021_66959_94457.jpg

LS view: Headwall and pipe at toe.

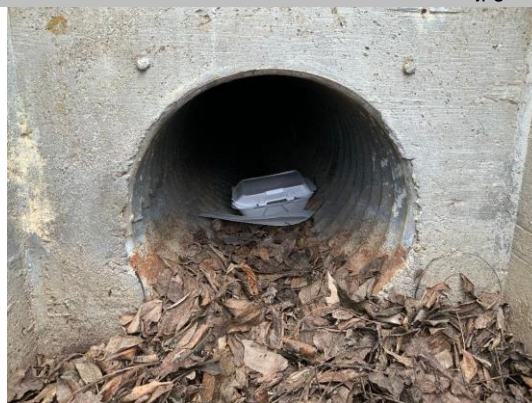
Photo 3 of 3 : UCIP_FA_2021_66959_94458.jpg

LS view: Inside pipe inlet.

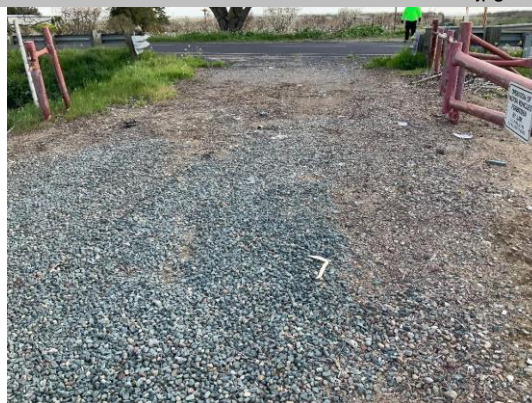
Photo 1 of 3 : UCIP_FA_2021_65502_94465.jpg

DS_ID:23238
FS_ID:65502
EP_NO: N/A
Repair Type: Non-Urgent
EVAL Issue: Maintenance Compliance Issue
Crossing Status: Found
UCIP Comments: 03/25/2021 Pipe status is still Non-Urgent. Unit 15 – Mormon Slough (CLM 0 to 1.50 and 5.0 - 11.0) are considered a patrol road/high ground area with no defined levee prism, any issue found between CLM 0 - 1.50 and 5.0 – 11.0 of Unit 15 will be considered a maintenance issue, or an unauthorized encroachment, or an abandoned encroachment. Cannot see inlet or pipe on LS, likely covered in trash or vegetation, recommend clearing out. DWR DMP internal video inspection has not found pipe integrity issues. LOF of crossing is less or equal to 4.0. Recommend next video inspection in 5 years. Current condition of pipe crossing does not impede access to patrol road/high ground area. No permit was found authorizing this encroachment. CVFPB will need to review crossing to determine owner. The UCIP inspection was completed with LMA representative, H. Latu. (H. Dunn – GEI) 04/10/2014 Pipe buried on landside. May need cleaning of vegetation debris in inlet opening. (P. Tariq - DWR UCIP)

FIELD_STRUCT_DESC: 18-inch corrugated metal drainage pipe through the levee, 7.5 feet below the crown. Flap gate on the waterside (WS). [Additional Reference(s): DWR Levee Log, 1992. USACE San Joaquin O&M Manual 611.1, Volume F, (HLM 10.49)].
FS Date: 3/25/2021

Levee crown looking upstream.

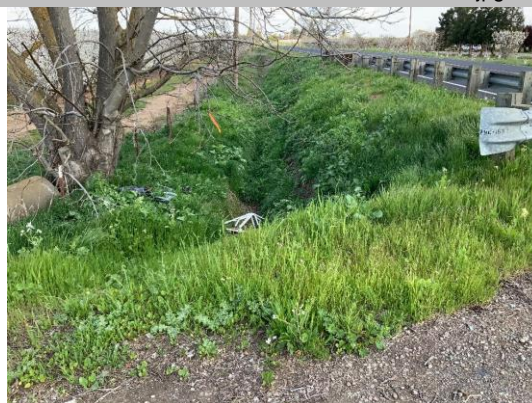
Photo 2 of 3 : UCIP_FA_2021_65502_94466.jpg

LS view: Toe from levee crown.

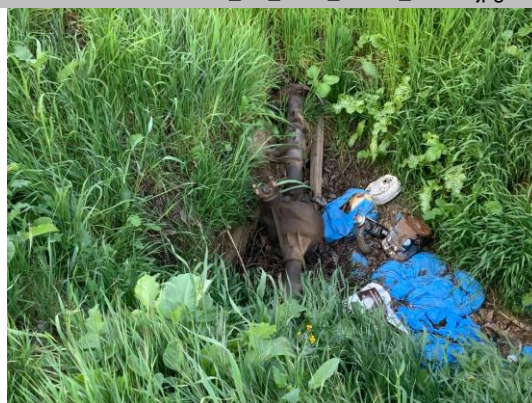
Photo 3 of 3 : UCIP_FA_2021_65502_94467.jpg

LS view: Trash and debris at toe, cannot see any inlet/pipe.

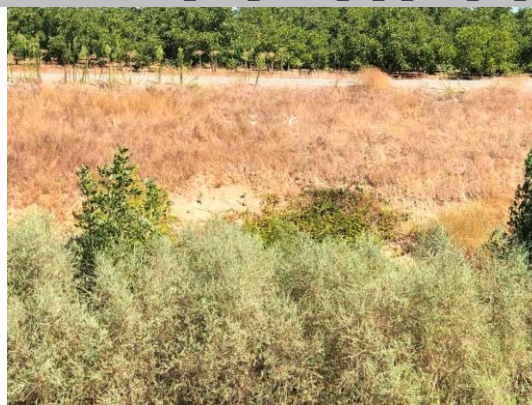
Photo 2 of 2 : SJR2021_DWR_NA0017_15_s _ 2018_143_4.JPG

8/28/2019: View of the erosion from the opposite bank.

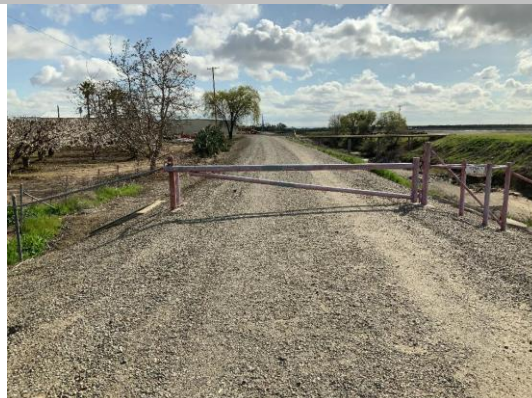
Photo 1 of 3 : UCIP_FA_2021_67088_94524.jpg

Comment Code					
Inspector Comment					
DS_ID:23243 FS_ID:67088 EP_NO: N/A Repair Type: Urgent EVAL Issue: Pipe Integrity Crossing Status: Found UCIP Comments: 03/25/2021 The record has been upgraded from Non-Urgent to Urgent. Pipe is heavily grouted around on WS, fairly hidden. No flapgate, open on both ends. DWR DMP internal video inspection has found pipe integrity issues. LOF of crossing is between 5 and 6. Crossing will be monitored until funding becomes available to address the issues. No permit was found authorizing this encroachment. CVFPB will need to review crossing to determine owner. The UCIP inspection was completed with LMA representative, H. Latu. (H. Dunn – GEI)					
04/14/2014 Distorted outlet pipe on waterside. (P. Andy - DWR UCIP) FIELD_STRUCT_DESC: 18-inch corrugated metal drainage pipe, 4 feet below the roadway. Grouted outlet on the waterside (WS). [Additional Reference(s): DWR Levee Log, 1992. USACE San Joaquin O&M Manual 611.1, Volume F, (HLM 11.64)]. FS Date: 3/25/2021

Levee crown looking upstream.

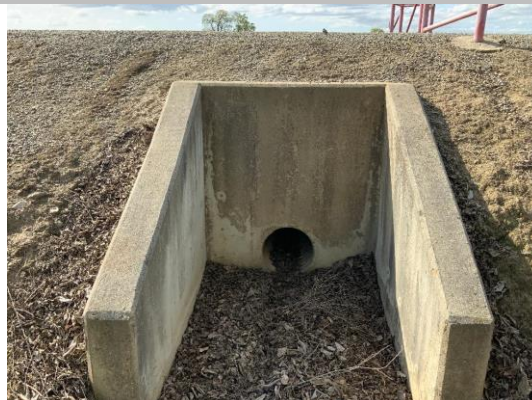
Photo 2 of 3 : UCIP_FA_2021_67088_94526.jpg

LS view: Headwall at toe.

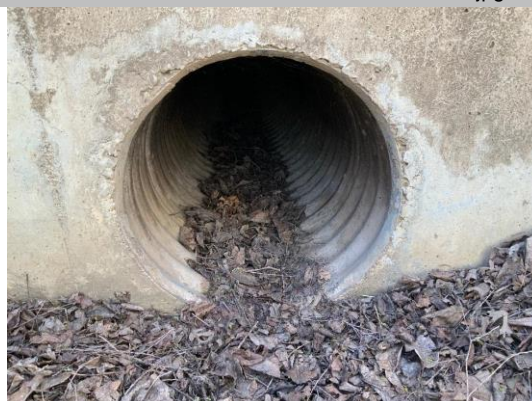
Photo 3 of 3 : UCIP_FA_2021_67088_94527.jpg

LS view: Inside pipe inlet.

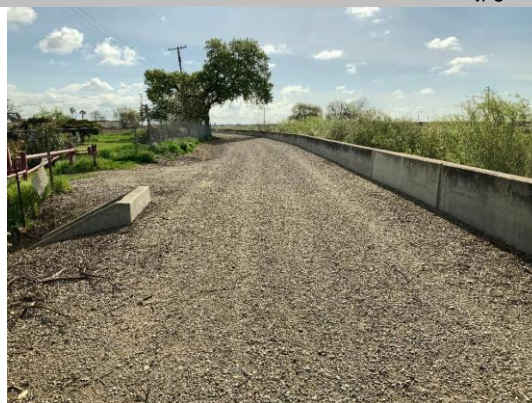
Photo 1 of 3 : UCIP_FA_2021_67087_94534.jpg

Levee crown looking upstream.

Comment Code					
Inspector Comment					
DS_ID:23244 FS_ID:67087 EP_NO: N/A Repair Type: Non-Urgent EVAL Issue: Unauthorized Encroachment, installed decades prior Crossing Status: Found UCIP Comments: 03/25/2021 The record has been upgraded from No Action Needed to Non-Urgent. DWR DMP internal video inspection has not found pipe integrity issues. LOF of crossing is less or equal to 4.0. Recommend next video inspection in 5 years. No permit was found authorizing this encroachment. CVFPB will need to review crossing to determine owner. The UCIP inspection was completed with LMA representative, H. Latu. (H. Dunn – GEI) 04/14/2014 New pipe and flapgate. (P. Andy - DWR UCIP) FIELD_STRUCT_DESC: 30-inch corrugated metal drainage pipe through the levee, 4.5 feet below the crown. Flap gate on the waterside (WS). Headwall with open inlet pipe on the landside (LS). Grouted outlet. [Additional Reference(s): DWR Levee Log, 1992, 18-inch pipe listed. USACE San Joaquin O&M Manual 611.1, Volume F, (HLM 11.79) 18-inch pipe listed]. FS Date: 3/25/2021

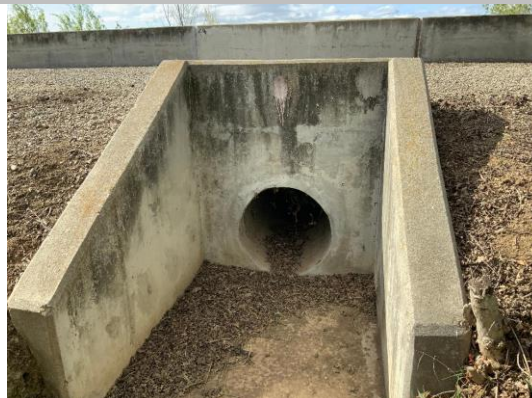
Photo 2 of 3 : UCIP_FA_2021_67087_94536.jpg

LS view: Headwall at toe.

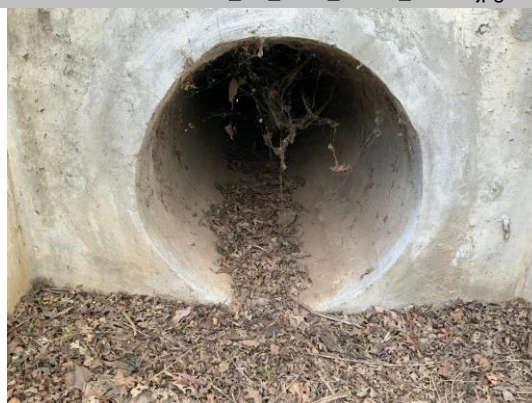
Photo 3 of 3 : UCIP_FA_2021_67087_94537.jpg

LS view: Inside of pipe inlet.

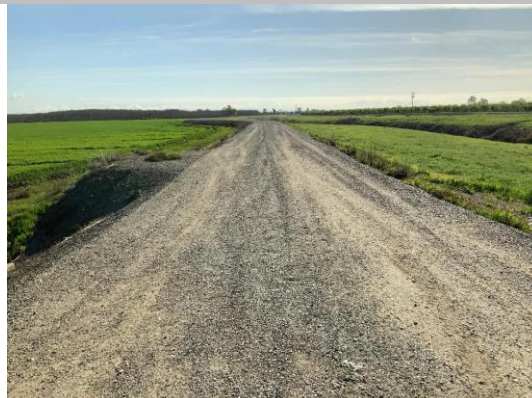
Photo 1 of 3 : UCIP_FA_2021_67086_94583.jpg

Comment Code					
Inspector Comment					
DS_ID:23247 FS_ID:67086 EP_NO: N/A Repair Type: Non-Urgent EVAL Issue: Unauthorized Encroachment, installed decades prior Crossing Status: Found UCIP Comments: 03/25/2021 The record has been upgraded from No Action Needed to Non- Urgent. DWR DMP internal video inspection has not found pipe integrity issues. LOF of crossing is less or equal to 4.0, Recommend next video inspection in 5 years. No permit was found authorizing this encroachment. CVFPB will need to review crossing to determine owner. The UCIP inspection was completed with LMA representative, H. Latu. (H. Dunn – GEI) 04/14/2014 May need mud and debris cleaning. (P. Andy - DWR UCIP) FIELD_STRUCT_DESC: 1 of 2: 48-inch drainage pipe of an unknown material through the levee, 11.5 feet below the crown. Slide gate in corrugated metal riser unit on the waterside (WS) slope. Concrete U-shaped headwall on both ends. Flap gates. Grouted rock spillway. [Additional Reference(s): DWR Levee Log, 1992. USACE San Joaquin O&M Manual 611.1, Volume F, (HLM 12.65) corrugated metal pipe listed]. FS Date: 3/25/2021

Levee crown looking upstream.

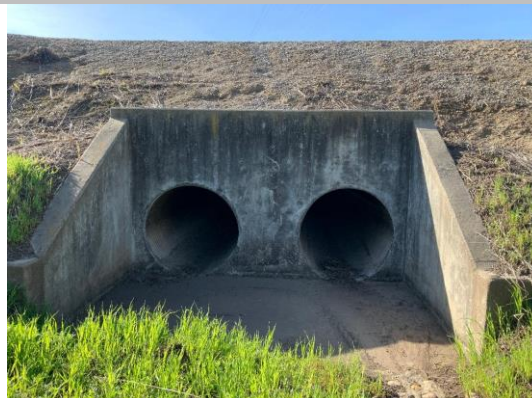
Photo 2 of 3 : UCIP_FA_2021_67086_94578.jpg

LS view: Headwall at toe.

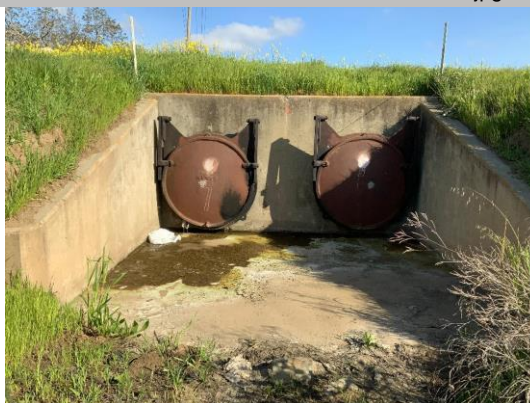
Photo 3 of 3 : UCIP_FA_2021_67086_94580.jpg

WS view: Headwall and flapgates at toe.

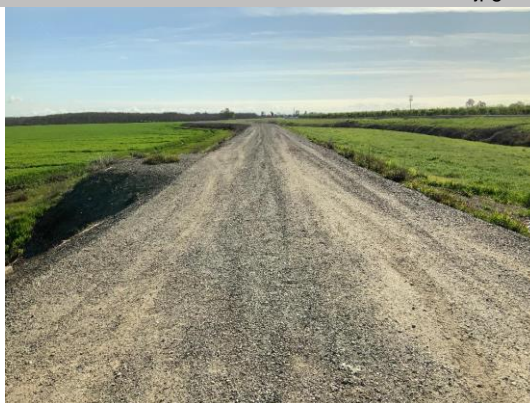
Photo 1 of 3 : UCIP_FA_2021_67085_94588.jpg

DS_ID:23454
 FS_ID:67085
 EP_NO: N/A
 Repair Type: Urgent
 EVAL Issue: Pipe Integrity
 Crossing Status: Found
 UCIP Comments: 03/25/2021 The record has been upgraded from No Action Needed to Urgent. Significant peeling of metal inside LS pipe. DWR DMP internal video inspection has found pipe integrity issues. LOF of crossing is between 5 and 6. Crossing will be monitored until funding becomes available to address the issues. No permit was found authorizing this encroachment. CVFPB will need to review crossing to determine owner. The UCIP inspection was completed with LMA representative, H. Latu. (H. Dunn – GEI) 04/14/2014 May need mud and debris cleaning. (P. Andy - DWR UCIP)
 FIELD_STRUCT_DESC: 2 of 2: 48-inch drainage pipe of an unknown material through the levee, 11.5 feet below the crown. Slide gate in corrugated metal riser units on the waterside (WS) slope. Concrete U-shaped headwall on both ends. Flap gates. Grouted rock spillway. [Additional Reference(s): DWR Levee Log, 1992. USACE San Joaquin O&M Manual 611.1, Volume F, (HLM 12.65) corrugated metal pipe listed].

Levee crown looking upstream.

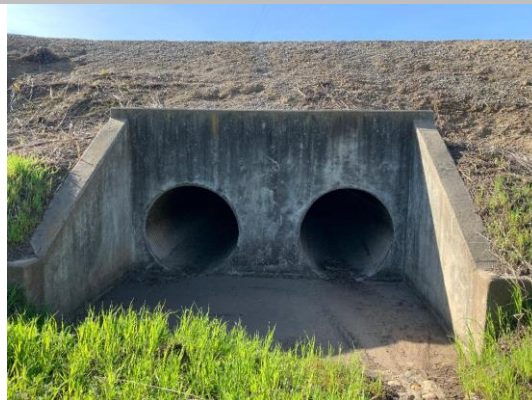
Photo 2 of 3 : UCIP_FA_2021_67085_94591.jpg

LS view: Headwall at toe.

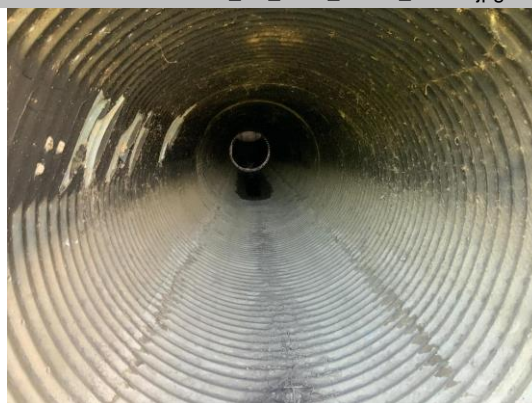
Photo 3 of 3 : UCIP_FA_2021_67085_94596.jpg

LS view: Peeling of metal inside pipe.

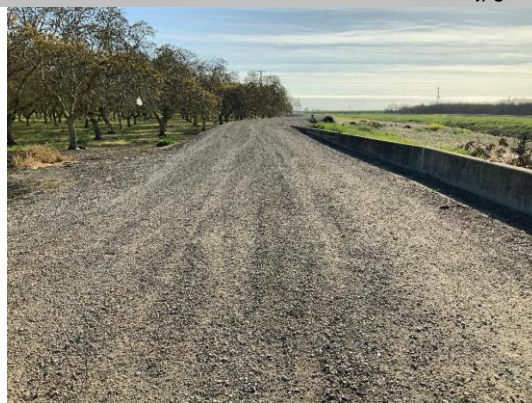
Photo 1 of 3 : UCIP_FA_2021_66972_94611.jpg

Comment Code						
Inspector Comment						
DS_ID:23249 FS_ID:66972 EP_NO: N/A Repair Type: Urgent EVAL Issue: Pipe Integrity Crossing Status: Found UCIP Comments: 03/25/2021 The record has been upgraded from No Action Needed to Urgent. DWR DMP internal video inspection has found pipe integrity issues. LOF of crossing is between 5 and 6. Minor erosion along LS headwall edges. Unknown plastic pipe underground adjacent to LS headwall, does not go through the levee. Crossing will be monitored until funding becomes available to address the issues. No permit was found authorizing this encroachment. CVFPB will need to review crossing to determine owner. The UCIP inspection was completed with LMA representative, H. Latu. (H. Dunn – GEI) 04/14/2014 May need cleaning of pipes. Flood wall on waterside shoulder. (P. Andy - DWR UCIP) FIELD_STRUCT_DESC: 30-inch corrugated metal drainage pipe through the levee, 8.5 feet below the crown. Concrete U-shaped headwall on both ends. Flap gate on the waterside (WS). Grouted intake and spillway. [Additional Reference(s): DWR Levee Log, 1992. USACE San Joaquin O&M Manual 611.1, Volume F, (HLM 12.83)]. FS Date: 3/25/2021

Levee crown looking upstream.

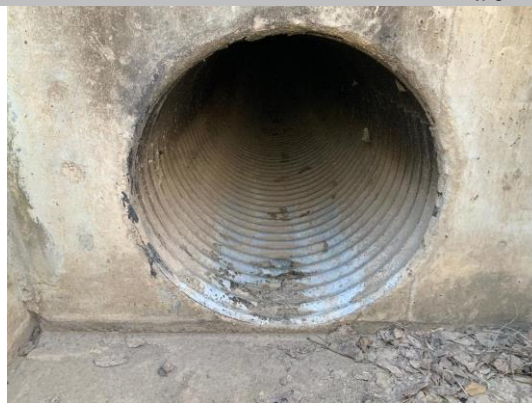
Photo 2 of 3 : UCIP_FA_2021_66972_94616.jpg

LS view: Close up of pipe inlet.

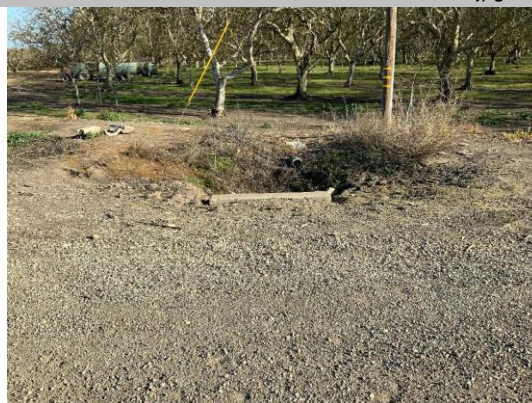
Photo 3 of 3 : UCIP_FA_2021_66972_94613.jpg

LS view: Headwall at toe from crown.

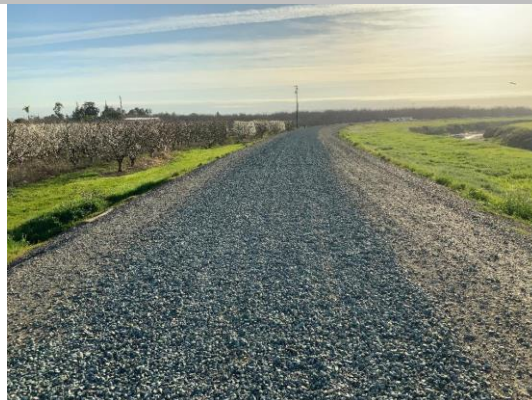
Photo 1 of 3 : UCIP_FA_2021_66975_94652.jpg

DS_ID:23252
FS_ID:66975
EP_NO: N/A
Repair Type: Non-Urgent
EVAL Issue: Unauthorized Encroachment, installed decades prior
Crossing Status: Found
UCIP Comments: 03/25/2021 Pipe status is still Non-Urgent. DWR DMP internal video inspection has not found pipe integrity issues. LOF of crossing is less or equal to 4.0. Recommend next video inspection in 5 years. No permit was found authorizing this encroachment. CVFPB will need to review crossing to determine owner. The UCIP inspection was completed with LMA representative, H. Latu. (H. Dunn – GEI)

Levee crown looking upstream.

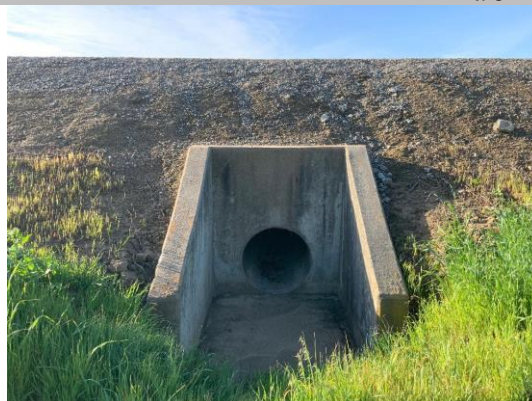
Photo 2 of 3 : UCIP_FA_2021_66975_94646.jpg

LS view: Headwall and slope at toe.

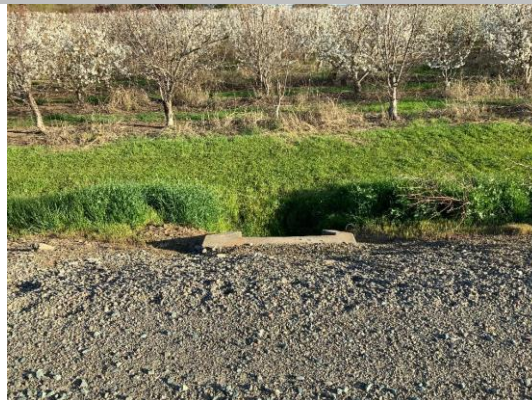
Photo 3 of 3 : UCIP_FA_2021_66975_94654.jpg

LS view: Headwall at toe from crown.

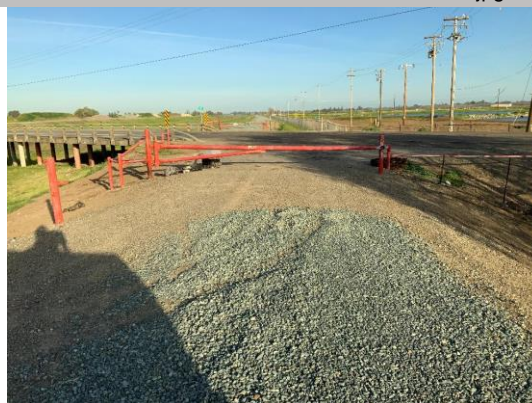
Photo 1 of 3 : UCIP_FA_2021_66977_95094.jpg

DS_ID:23254
 FS_ID:66977
 EP_NO: N/A
 Repair Type: Non-Urgent
 EVAL Issue: Unauthorized Encroachment, installed decades prior
 Crossing Status: Found
 UCIP Comments: 03/25/2021 Pipe status is still Non-Urgent. No permit was found authorizing this encroachment. CVFPB will need to review crossing to determine owner. The UCIP inspection was completed with LMA representative, H. Latu. (H. Dunn – GEI) 04/14/2014 Needs cleaning. (P. Andy - DWR UCIP)
 FIELD_STRUCT_DESC: 36-inch corrugated metal storm drainage pipe through the levee, 8.5 feet below the crown. Concrete U-shaped headwalls on both ends. Flap gate on the waterside (WS). Grouted spillway. [Additional Reference(s): DWR Levee Log, 1992. USACE San Joaquin O&M Manual 611.1, Volume F, (Station 0+79)].
 FS Date: 3/25/2021

Levee crown looking upstream.

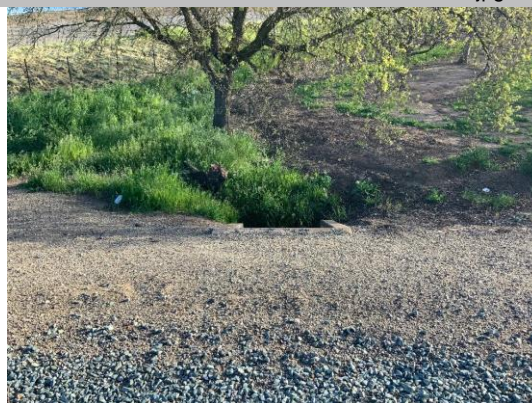
Photo 2 of 3 : UCIP_FA_2021_66977_95095.jpg

LS view: Headwall visible at toe from crown.

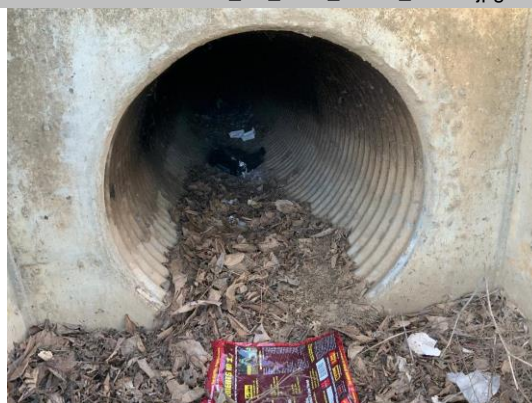
Photo 3 of 3 : UCIP_FA_2021_66977_95097.jpg

LS view: Inside pipe inlet.

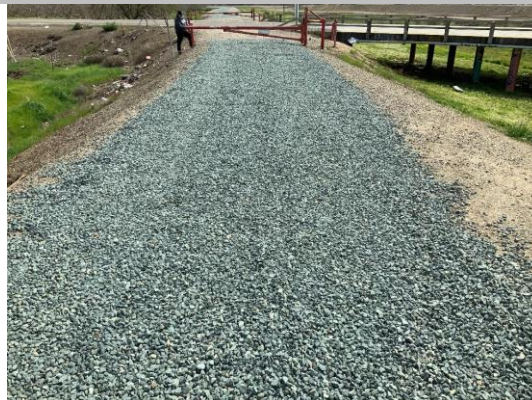
Photo 1 of 3 : UCIP_FA_2021_66979_95108.jpg

Comment Code					
Inspector Comment					
DS_ID:23257 FS_ID:66979 EP_NO: N/A Repair Type: Urgent EVAL Issue: Pipe Integrity Crossing Status: Found UCIP Comments: 03/22/2021 The record has been upgraded from No Action Needed to Urgent. DWR DMP internal video inspection has found pipe integrity issues. LOF of crossing is between 5 and 6. Crossing will be monitored until funding becomes available to address the issues. No permit was found authorizing this encroachment. CVFPB will need to review crossing to determine owner. The UCIP inspection was completed with LMA representative, J. Jauregui. (H. Dunn – GEI) 04/14/2014 May need cleaning. (P. Andy - DWR UCIP) FIELD_STRUCT_DESC: 30-inch corrugated metal drainage pipe through the levee, 9.5 feet below the crown. Concrete U-shaped headwalls on both ends. Grouted spillway and intake. Flap gate on the waterside (WS). [Additional Reference(s): DWR Levee Log, 1992. USACE San Joaquin O&M Manual 611.1, Volume F, (HLM 13.79)]. FS Date: 3/22/2021

Levee crown looking upstream.

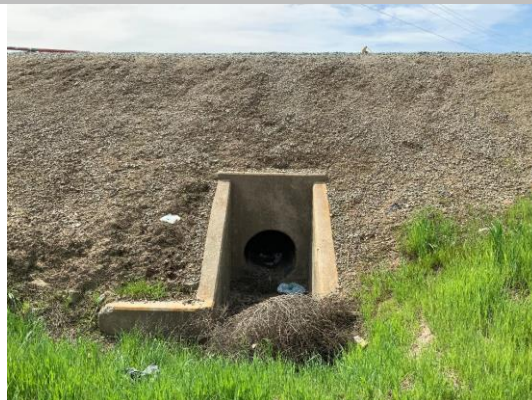
Photo 2 of 3 : UCIP_FA_2021_66979_95110.jpg

LS view: Headwall at toe.

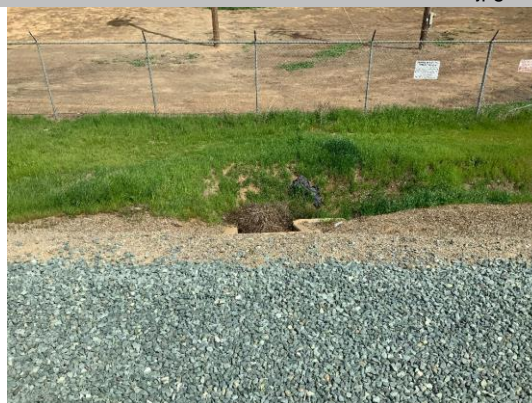
Photo 3 of 3 : UCIP_FA_2021_66979_95109.jpg

LS view: Headwall visible at toe from crown.

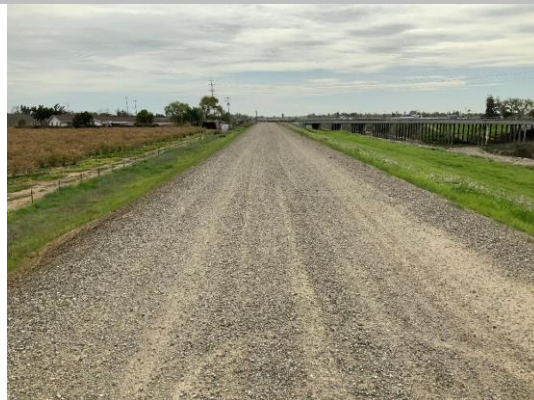
Photo 1 of 3 : UCIP_FA_2021_66990_95201.jpg

Comment Code					
Inspector Comment					
DS_ID:23188 FS_ID:66990 EP_NO: N/A Repair Type: Urgent EVAL Issue: Pipe Integrity Crossing Status: Found UCIP Comments: 03/22/2021 The record has been upgraded from No Action Needed to Urgent. DWR DMP internal video inspection has found pipe integrity issues. LOF of crossing is between 5 and 6. Crossing will be monitored until funding becomes available to address the issues. No permit was found authorizing this encroachment. CVFPB will need to review crossing to determine owner. The UCIP inspection was completed with LMA representative, J. Jauregui. (H. Dunn – GEI) 04/15/2014 May need cleaning. (P. Andy - DWR UCIP) FIELD_STRUCT_DESC: 30-inch corrugated metal drainage pipe through the levee, 9.5 feet below the crown. Concrete U-shaped headwall on both ends. Grouted spillway and intake. Flap gate on the waterside (WS). [Additional Reference(s): DWR Levee Log, 1992. USACE San Joaquin O&M Manual 611.1, Volume F, (HLM 15.58)]. FS Date: 3/22/2021

Levee crown looking upstream.

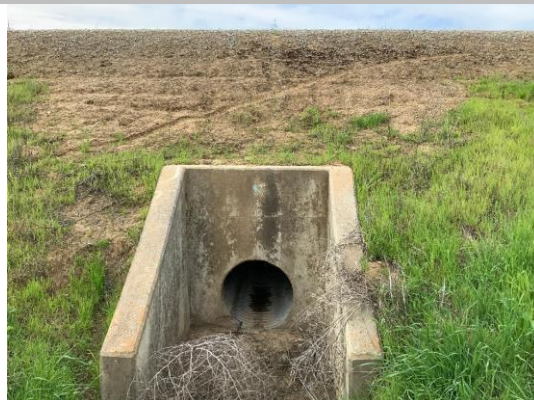
Photo 2 of 3 : UCIP_FA_2021_66990_95203.jpg

LS view: Headwall at toe.

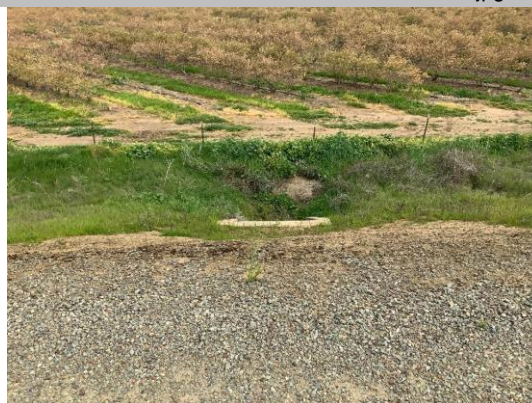
Photo 3 of 3 : UCIP_FA_2021_66990_95202.jpg

LS view: Headwall visible at toe from crown.

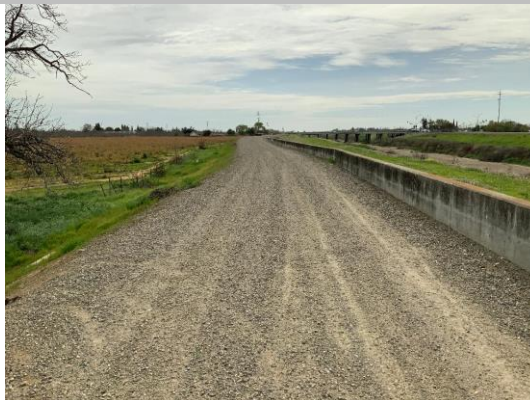
Photo 1 of 3 : UCIP_FA_2021_66992_95208.jpg

Comment Code					
Inspector Comment					
DS_ID:23189 FS_ID:66992 EP_NO: N/A Repair Type: Non-Urgent EVAL Issue: Pipe Damage Crossing Status: Found UCIP Comments: 03/22/2021 The record has been upgraded from No Action Needed to Non-Urgent. DWR DMP internal video inspection has found pipe integrity issues. LOF of crossing is between 4.1 and 5. Crossing will be monitored until funding becomes available for rehabilitation. No permit was found authorizing this encroachment. CVFPB will need to review crossing to determine owner. The UCIP inspection was completed with LMA representative, J. Jauregui. (H. Dunn – GEI) 04/15/2014 May need cleaning. (P. Andy - DWR UCIP) FIELD_STRUCT_DESC: 30-inch corrugated metal drainage pipe through the levee, 9.5 feet below the crown. Concrete U-shaped headwall on both ends. Grouted spillway and intake. Flap gate. [Additional Reference(s): DWR Levee Log, 1992. USACE San Joaquin O&M Manual 611.1, Volume F, (HLM 15.70)]. FS Date: 3/22/2021

Levee crown looking upstream.

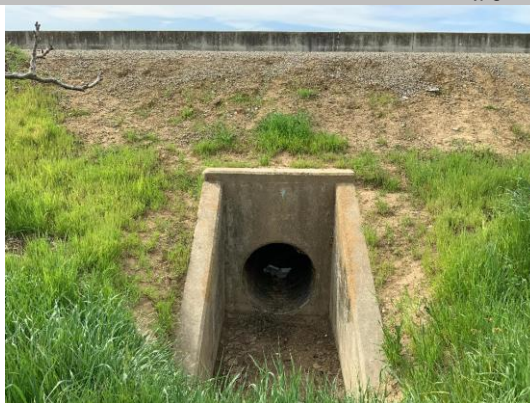
Photo 2 of 3 : UCIP_FA_2021_66992_95210.jpg

LS view: Headwall at toe.

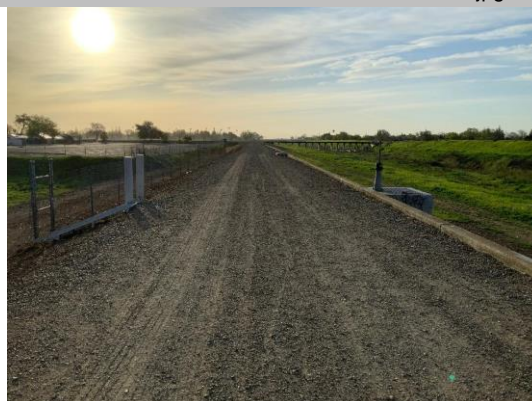
Photo 1 of 3 : UCIP_FA_2021_67012_95332.jpg

Comment Code						
Inspector Comment						
DS_ID:23265 FS_ID:67012 EP_NO: N/A Repair Type: Non-Urgent EVAL Issue: Unauthorized Encroachment, installed decades prior Crossing Status: Found UCIP Comments: 03/22/2021 The record has been upgraded from No Action Needed to Non-Urgent. DWR DMP internal video inspection has not found pipe integrity issues. LOF of crossing is less or equal to 4.0. Recommend next video inspection in 5 years. No permit was found authorizing this encroachment. CVFPB will need to review crossing to determine owner. The UCIP inspection was completed with LMA representative, J. Jauregui. (H. Dunn – GEI) 10/27/2017 This structure is inspected annually under the Structure and Channel Summer Inspection (part of the Levee Inspection Program) conducted by the DWR Flood Project Integrity and Inspection Branch (FPIIB). (DWR UCIP - O. Magana) Adjacent pipes are: two 14-inch pipes through the levee 3.0 feet below the crown. Steel trash rack on landside intake. FIELD_STRUCT_DESC: [Mormon Slough Pumping Plant No. 1] 1 of 3: 30-inch by 30-inch reinforced concrete box drainage culvert through the levee, 17.6 feet below the crown. Slide gate in riser unit on the waterside (WS) slope. Flap gate on the WS end. Concrete U-shaped headwall around all three pipes on the WS. Intake under the pump house on the landside (LS). Steel steps on the LS slope. [Additional Reference(s): DWR Levee Log, 1992. USACE San Joaquin O&M Manual 611.1, Volume F, (HLM 17.74)]. FS Date: 3/22/2021

Levee crown looking upstream.

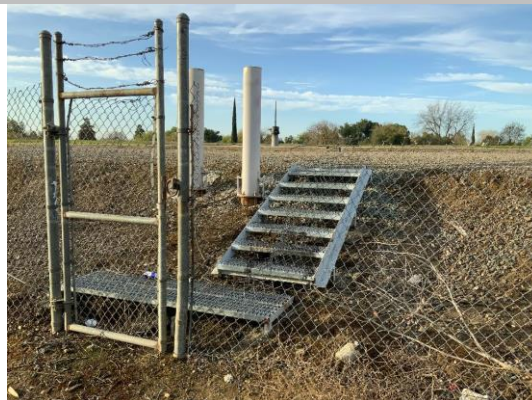
Photo 2 of 3 : UCIP_FA_2021_67012_95334.jpg

LS view: Slope from toe, stairs and standpipe.

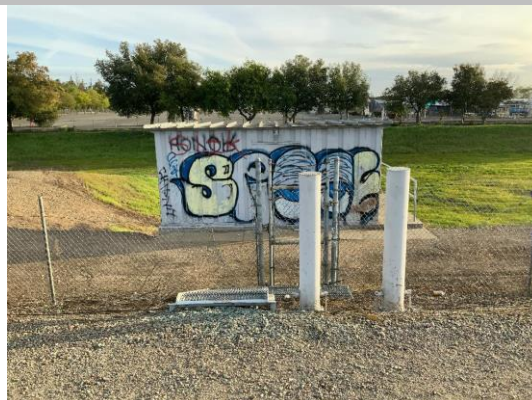
Photo 3 of 3 : UCIP_FA_2021_67012_95333.jpg

LS view: Toe from crown, pump station and standpipes.

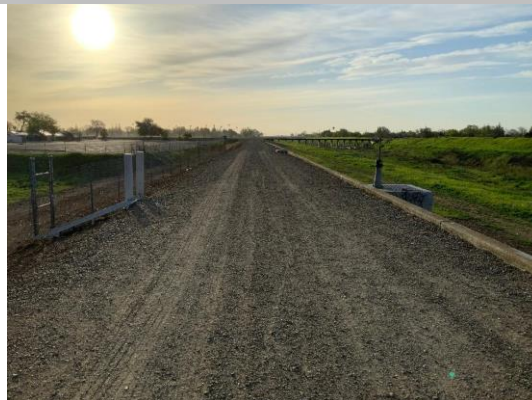
Photo 1 of 3 : UCIP_FA_2021_67013_95344.jpg

DS_ID:23460
FS_ID:67013
EP_NO: N/A
Repair Type: Non-Urgent
EVAL Issue: Unauthorized Encroachment, installed decades prior
Crossing Status: Found
UCIP Comments: 03/22/2021 The record has been upgraded from No Action Needed to Non-Urgent. No permit was found authorizing this encroachment. CVFPB will need to review crossing to determine owner. The UCIP inspection was completed with LMA representative, J. Jauregui. (H. Dunn – GEI) 10/27/2017 This structure is inspected annually under the Structure and Channel Summer Inspection (part of the Levee Inspection Program) conducted by the DWR Flood Project Integrity and Inspection Branch (FPIIB). (DWR UCIP - O. Magana)
Adjacent pipe is: 30-inch by 30-inch RC box culvert through the levee 17.6 feet below the crown. Steel trash rack on landside intake.
FIELD_STRUCT_DESC: [Mormon Slough Pumping Plant No. 1] 2 of 3: 14-inch steel drainage pipe through the levee, 3 feet below the crown. Siphon breakers in 4-foot high riser units on the landside (LS) shoulder. Flap gates on the waterside (WS) end. Concrete U-shaped headwall around all three pipes on the WS. Pump house on the LS. Steel steps on the LS slope. [Additional Reference(s): DWR Levee Log, 1992. USACE San Joaquin O&M Manual 611.1, Volume F, (HLM 17.74)].

Levee crown looking upstream.

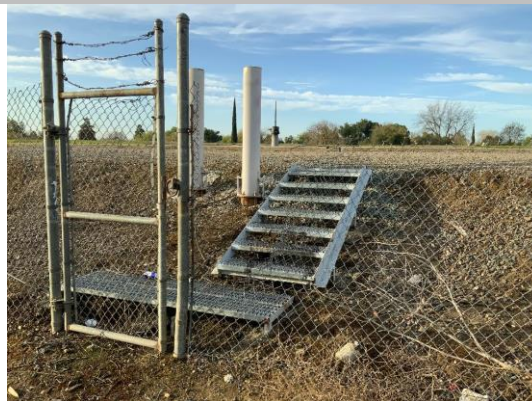
Photo 2 of 3 : UCIP_FA_2021_67013_95347.jpg

LS view: Slope from toe.

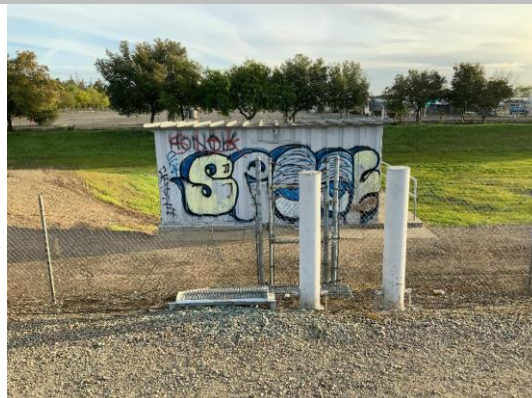
Photo 3 of 3 : UCIP_FA_2021_67013_95346.jpg

LS view: Toe from crown, pump station and risers.

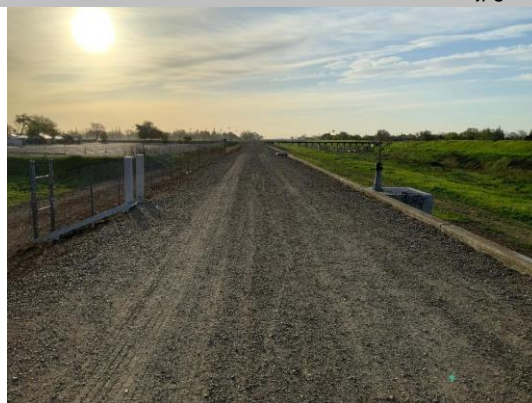
Photo 1 of 3 : UCIP_FA_2021_67014_95356.jpg

DS_ID:23461
 FS_ID:67014
 EP_NO: N/A
 Repair Type: Non-Urgent
 EVAL Issue: Unauthorized Encroachment, installed decades prior
 Crossing Status: Found
 UCIP Comments: 03/22/2021 The record has been upgraded from No Action Needed to Non-Urgent. No permit was found authorizing this encroachment. CVFPB will need to review crossing to determine owner. The UCIP inspection was completed with LMA representative, J. Jauregui. (H. Dunn – GEI) 10/27/2017 This structure is inspected annually under the Structure and Channel Summer Inspection (part of the Levee Inspection Program) conducted by the DWR Flood Project Integrity and Inspection Branch (FPIIB). (DWR UCIP - O. Magana)
 Adjacent pipe is: 30-inch by 30-inch RC box culvert through the levee 17.6 feet below the crown. Steel trash rack on landside.
 FIELD_STRUCT_DESC: [Mormon Slough Pumping Plant No. 1] 3 of 3: 14-inch steel drainage pipe through the levee, 3 feet below the crown. Siphon breakers in 4-foot high riser units on the landside (LS) shoulder. Flap gates on the waterside (WS) end. Concrete U-shaped headwall around all three pipes on the WS. Pump house on the LS. Wooden steps on the LS slope. [Additional Reference(s): DWR Levee Log, 1992. USACE San Joaquin O&M Manual 611.1, Volume F, (HLM 17.74)].

Levee crown looking upstream.

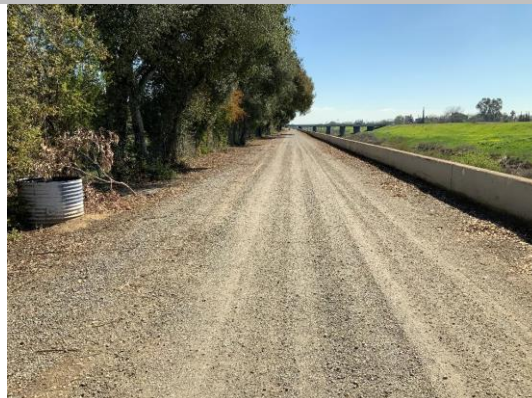
Photo 1 of 3 : UCIP_FA_2021_67018_96286.jpg

DS_ID:23267
FS_ID:67018
EP_NO: N/A
Repair Type: Non-Urgent
EVAL Issue: Safety Issue
Crossing Status: Found
UCIP Comments: 03/12/2021 Pipe status is still Non-Urgent. No cover on LS riser. Could not inspect LS pipe end due to fence for golf course. DWR DMP internal video inspection has not found pipe integrity issues. LOF of crossing is less or equal to 4.0. Recommend next video inspection in 5 years. No permit was not found authorizing this encroachment. CVFPB will need to review crossing to determine owner. The UCIP inspection was completed with LMA representative, J. Jauregui. (H. Dunn – GEI) 04/15/2014 CMP riser needs cleaning. (P. Taroq - DWR UCIP)
FIELD_STRUCT_DESC: 30-inch corrugated metal drainage pipe through the levee, 13 feet below the crown. Concrete U-shaped headwall on the waterside (WS). Corrugated metal riser unit at the landside (LS) toe. [Additional Reference(s): DWR Levee Log, 1992. USACE San Joaquin O&M Manual 611.1, Volume F, (HLM 18.01)].

Levee crown looking upstream.

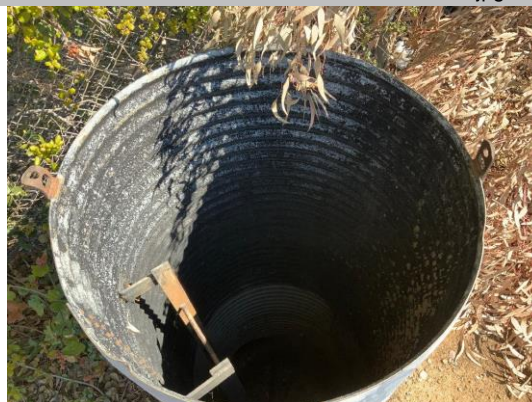
Photo 2 of 3 : UCIP_FA_2021_67018_96288.jpg

LS view: Inside metal riser, missing cover.

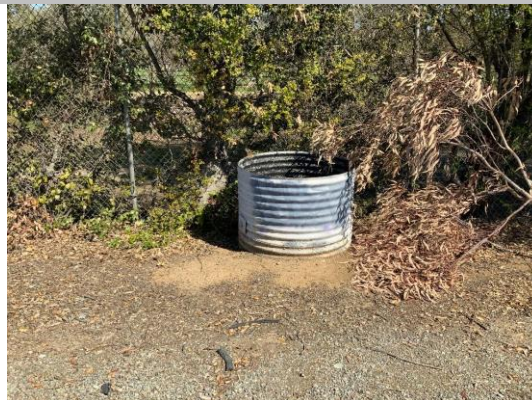
Photo 3 of 3 : UCIP_FA_2021_67018_96287.jpg

LS view: Toe from crown, fence behind CMP riser, cannot access.

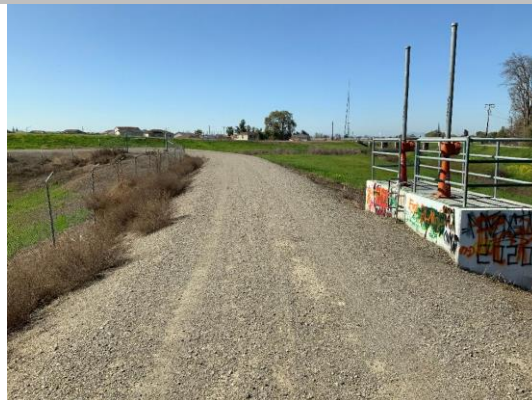
Photo 1 of 3 : UCIP_FA_2021_67020_96302.jpg

Comment Code						
Inspector Comment						
DS_ID:23462 FS_ID:67020 EP_NO: N/A Repair Type: Non-Urgent EVAL Issue: Unauthorized Encroachment, installed decades prior Crossing Status: Found UCIP Comments: 03/12/2021 The record has been upgraded from No Action Needed to Non-Urgent. No permit was found authorizing this encroachment. CVFPB will need to review crossing to determine owner. The UCIP inspection was completed with LMA representative, J. Jauregui. (H. Dunn – GEI) 04/15/2014 Slide gate in a concrete box on landside shoulder. (P. Tariq - DWR UCIP)Concrete headwall and flapgates on waterside. FIELD_STRUCT_DESC: Double 72-inch by 72-inch reinforced concrete box return structure through the levee, at an unknown depth. Slide gate in a concrete box on the landside (LS) shoulder. Concrete headwall and flap gates on the waterside (WS). [Additional Reference(s): USACE San Joaquin O&M Manual 611.1, Volume F, (Station 310+46)]. FS Date: 3/12/2021

Levee crown looking upstream.

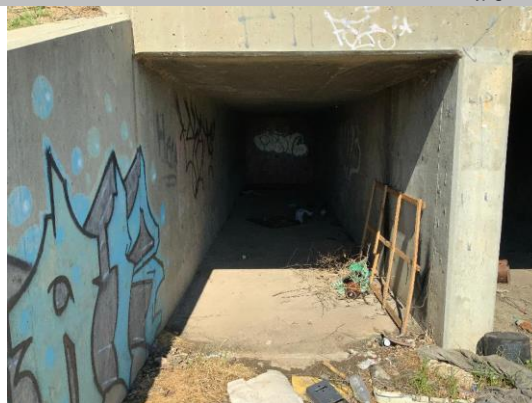
Photo 2 of 3 : UCIP_FA_2021_67020_96299.jpg

LS view: Headwall at toe, 1 of 2 photos.

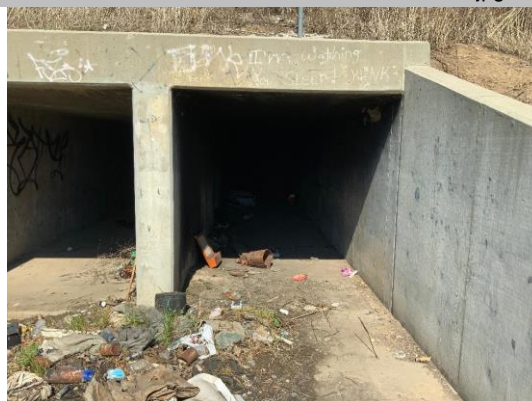
Photo 3 of 3 : UCIP_FA_2021_67020_96300.jpg

LS view: Headwall at toe, 2 of 2 photos.

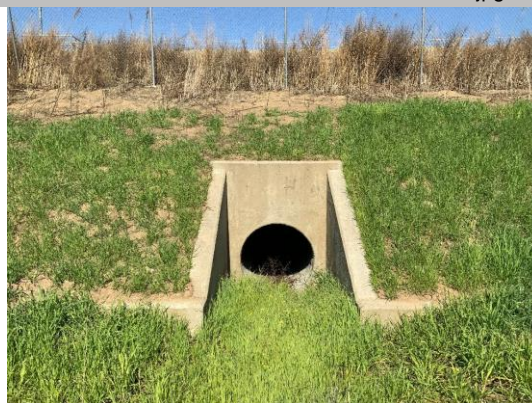
Photo 1 of 3 : UCIP_FA_2021_67021_96316.jpg

DS_ID:23269
FS_ID:67021
EP_NO: N/A
Repair Type: Non-Urgent
EVAL Issue: Safety Issue
Crossing Status: Found
UCIP Comments: 03/12/2021 Pipe status is still Non-Urgent. WS riser is missing the cover. DWR DMP internal video inspection has not found pipe integrity issues. LOF of crossing is less or equal to 4.0. Recommend next video inspection in 5 years. Some minor erosion above the WS headwall and a foot wide hole under the riprap on one outer edge of the headwall, see pics. No permit was found authorizing this encroachment. CVFPB will need to review crossing to determine owner. The UCIP inspection was completed with LMA representative, J. Jauregui. (H. Dunn – GEI) 04/15/2014 Slide gate handle missing. Vegetation on both inlet and outlet box. (P. Tariq - DWR UCIP)
FIELD_STRUCT_DESC: 36-inch corrugated metal drainage pipe through the levee, 15 feet below the crown. Concrete U-shaped headwall on both levee sides. Slide gate in corrugated metal riser unit on the waterside (WS) slope. Flap gate on the WS end. [Additional Reference(s): DWR Levee Log, 1992. USACE San Joaquin O&M Manual 611.1, Volume F, (HLM 18.54)].

LS view: Headwall at toe.

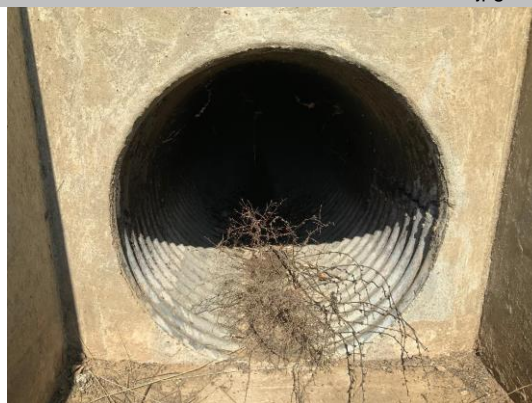
Photo 2 of 3 : UCIP_FA_2021_67021_96317.jpg

LS view: Inside pipe inlet.
