**Flood Control Project Maintenance
Levee Inspections**

Maintenance Issue Types Only, Levee Inspection Report By Mile - Fall 2021

San Joaquin County Flood Control and Water Conservation District

Waterway	Bank	Unit Miles	Inspection Start/End	Inspector
Unit No. 01 Littlejohn Creek	Left	2.59	10/21/2021 10/21/2021	Alberto De Leon

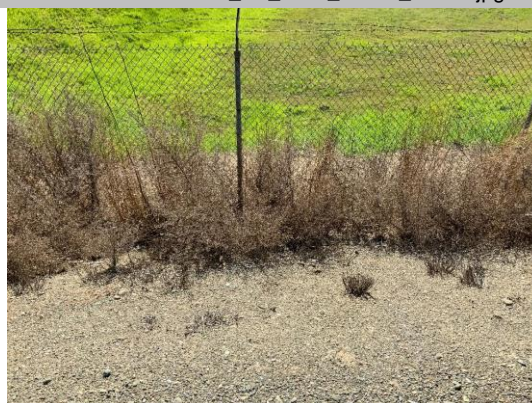
Photo 3 of 3 : UCIP_FA_2021_67021_96315.jpg

DS_ID:23269
FS_ID:67021
EP_NO: N/A
Repair Type: Non-Urgent
EVAL Issue: Safety Issue
Crossing Status: Found
UCIP Comments: 03/12/2021 Pipe status is still Non-Urgent. WS riser is missing the cover. DWR DMP internal video inspection has not found pipe integrity issues. LOF of crossing is less or equal to 4.0. Recommend next video inspection in 5 years. Some minor erosion above the WS headwall and a foot wide hole under the riprap on one outer edge of the headwall, see pics. No permit was found authorizing this encroachment. CVFPB will need to review crossing to determine owner. The UCIP inspection was completed with LMA representative, J. Jauregui. (H. Dunn – GEI) 04/15/2014 Slide gate handle missing. Vegetation on both inlet and outlet box. (P. Tariq - DWR UCIP)
FIELD_STRUCT_DESC: 36-inch corrugated metal drainage pipe through the levee, 15 feet below the crown. Concrete U-shaped headwall on both levee sides. Slide gate in corrugated metal riser unit on the waterside (WS) slope. Flap gate on the WS end. [Additional Reference(s): DWR Levee Log, 1992. USACE San Joaquin O&M Manual 611.1, Volume F, (HLM 18.54)].

LS view: Toe from crown.

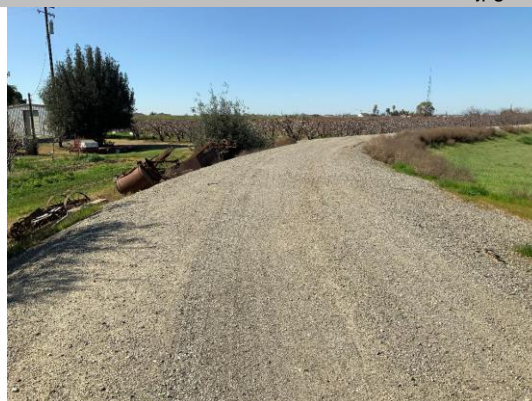
Photo 1 of 3 : UCIP_FA_2021_64907_96320.jpg

Comment Code						
Inspector Comment						
DS_ID:23270 FS_ID:64907 EP_NO: N/A Repair Type: Urgent EVAL Issue: Pipe Integrity Crossing Status: Found UCIP Comments: 03/12/2021 The record has been upgraded from No Action Needed to Urgent. Inside of LS pipe is protruded down and there is metal peeling away around the pipe a few feet in. Recommend internal video inspection to verify pipe integrity. No permit was found authorizing this encroachment. CVFPB will need to review crossing to determine owner. The UCIP inspection was completed with LMA representative, J. Jauregui. (H. Dunn – GEI) FIELD_STRUCT_DESC: 30-inch steel drainage pipe through the levee, 7 feet below the crown. Concrete U-shaped headwall on both ends. Grouted spillway. Flap gate on the waterside (WS) end. [Additional Reference(s): DWR Levee Log, 1992. USACE San Joaquin O&M Manual 611.1, Volume F, (HLM 18.68) corrugated metal pipe listed]. FS Date: 3/12/2021

Levee crown looking upstream.

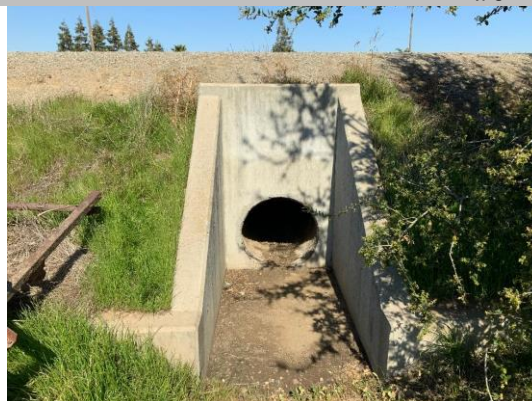
Photo 2 of 3 : UCIP_FA_2021_64907_96323.jpg

LS view: Headwall at toe.

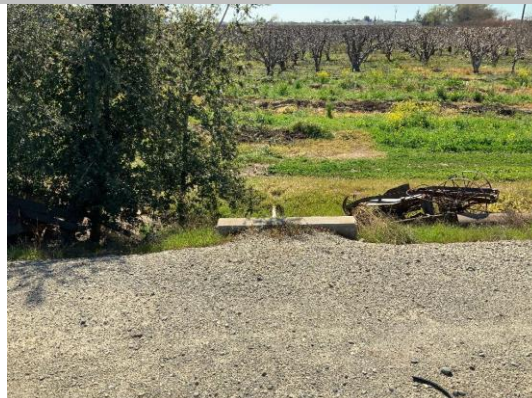
Photo 3 of 3 : UCIP_FA_2021_64907_96322.jpg

LS view: Headwall visible at toe from crown.

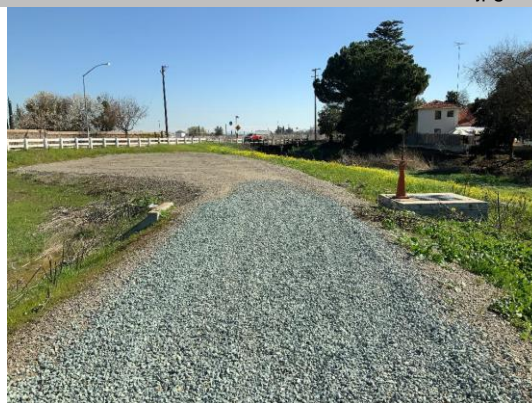
Photo 1 of 3 : UCIP_FA_2021_67023_96339.jpg

DS_ID:23464
 FS_ID:67023
 EP_NO: N/A
 Repair Type: Non-Urgent
 EVAL Issue: Maintenance Compliance Issue
 Crossing Status: Found
 UCIP Comments: 03/12/2021 The record has been upgraded from No Action Needed to Non-Urgent. Vegetation debris and trash seen in LS pipe, recommend cleaning out. No permit was found authorizing this encroachment. CVFPB will need to review crossing to determine owner. The UCIP inspection was completed with LMA representative, J. Jauregui. (H. Dunn – GEI) 04/15/2014 Slide gate in a concrete box on waterside shoulder. (P. tariq - DWR UCIP)
 FIELD_STRUCT_DESC: 30-inch reinforced concrete storm drainage pipe through the levee, 6 feet below the crown. Slide gate in a concrete box on the waterside (WS) shoulder. [Additional Reference(s): USACE San Joaquin O&M Manual 611.1, Volume F, (Station 345+65)].
 FS Date: 3/12/2021

Levee crown looking upstream.

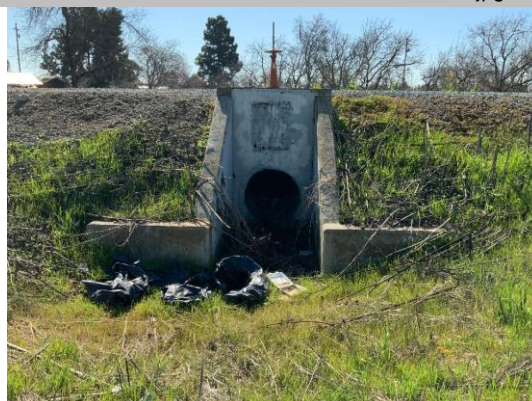
Photo 2 of 3 : UCIP_FA_2021_67023_96341.jpg

LS view: Headwall at toe.

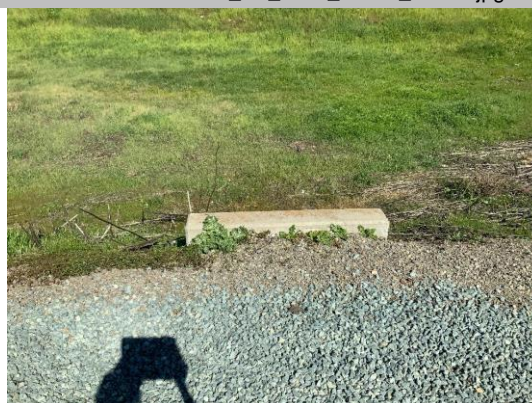
Photo 3 of 3 : UCIP_FA_2021_67023_96340.jpg

LS view: Headwall visible at toe from crown.

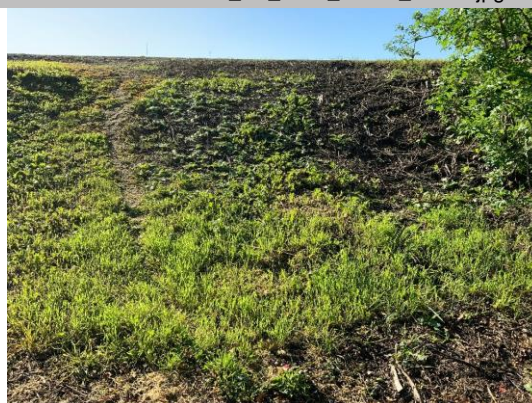
Photo 3 of 3 : UCIP_FA_2021_67031_96406.jpg

Comment Code					
Inspector Comment					
DS_ID:23274 FS_ID:67031 EP_NO: N/A Repair Type: Urgent EVAL Issue: Pipe Integrity Crossing Status: Found UCIP Comments: 03/12/2021 Record has been upgraded from Non-Urgent to Urgent. DWR DMP internal video inspection has found pipe integrity issues. LOF of crossing is between 5 and 6. Crossing will be monitored until funding becomes available to address the issues. Cannot see LS manhole due to vegetation debris. WS flapgate overgrown with vegetation, recommend clearing. Based on previous inspection, a concrete block was found within the pipe so it is presumed abandoned, need confirmation from the owner. No permit was found authorizing this encroachment. CVFPB will need to review crossing to determine owner. The UCIP inspection was completed with LMA representative, J. Jauregui. (H. Dunn – GEI)11/16/2018 Internal video inspection revealed a concrete plug in the pipe, 49.2 feet from the outlet on the WS. Pipe improperly abandoned. Abandon properly or remove from levee. Crossing escalated to "Non-Urgent" due to the improper abandonment. Material type changed from steel to reinforced concrete. (A. McDonald - DWR UCIP)Concrete headwall not found on the LS. Manhole found on the LS. FIELD_STRUCT_DESC: 24-inch reinforced concrete gravity drainage pipe through the levee, 12 feet below the crown. Flap gate and concrete headwall on the waterside (WS). Manhole on the landside (LS). Pipe partially plugged with concrete on the LS. [Additional Reference(s): DWR Levee Log, 1992. USACE San Joaquin O&M Manual 611.1, Volume F, (HLM 20.14)]. FS Date: 3/12/2021

LS view: Slope from toe.

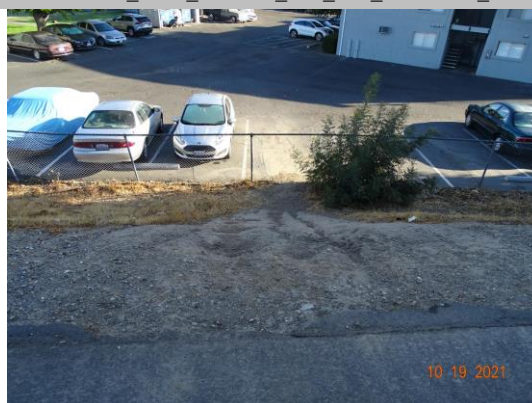
Photo 1 of 1 : FA_2021_NA0017_159_134_20211019_00507.jpg

LM Start	22.26	Rating **	M	Issue No.	134
LM End	22.26	Issue Type +	Ma	Location *	LS
Category	Earthen Levee			GPS Latitude/Longitude	
				Start	End
Item	Slope Stability			37.980937 °	37.980937 °
				-121.319809 °	-121.319809 °
DWR ID	DWR_NA0017_15_s_2020_134				
Comment Code					
S2 : Repair the levee slope damaged by foot traffic and prevent access where possible.					
Inspector Comment

View of pedestrian path on landside slope. Fall 2021

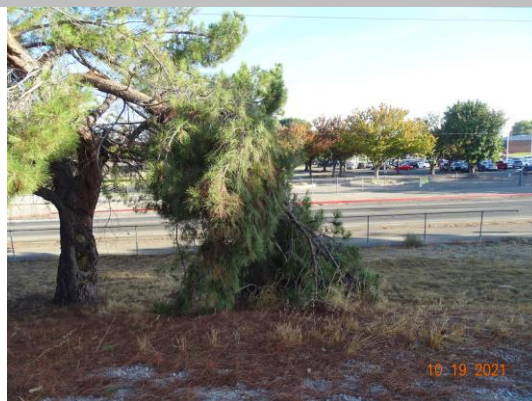
Photo 1 of 1 : FA_2021_NA0017_159_190_20211019_00506.jpg

LM Start	22.55	Rating **	M	Issue No.	190
LM End	22.55	Issue Type +	Ma	Location *	LS
Category	Earthen Levee			GPS Latitude/Longitude	
				Start	End
Item	Trim / Thin Trees			37.981920 °	37.981920 °
				-121.324943 °	-121.324943 °
DWR ID	DWR_NA0017_15_f_2019_190				
Comment Code					
T3 : Trim and thin trees to allow visibility of the ground and room to flood fight.					
Inspector Comment

View of broken off tree branch on landside slope. Fall 2021

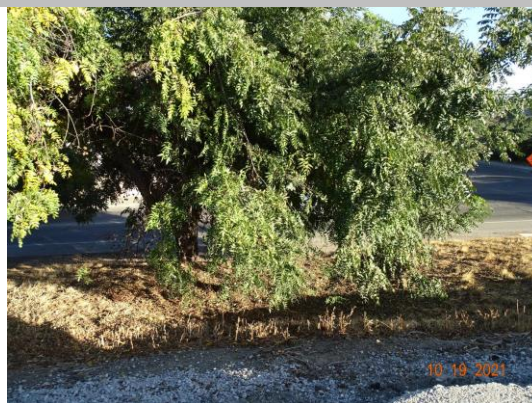
Photo 1 of 1 : FA_2021_NA0017_159_169_20211019_00505.jpg

LM Start	23.39	Rating **	M	Issue No.	169
LM End	23.39	Issue Type +	Ma	Location *	LS
Category	Earthen Levee			GPS Latitude/Longitude	
				Start	End
Item	Trim / Thin Trees			37.980029 °	37.980029 °
				-121.339587 °	-121.339587 °
DWR ID	DWR_NA0017_15_f_2019_169				
Comment Code					
T1 : Trim trees to at least five feet above ground level.					
Inspector Comment

View of untrimmed tree along landside easement. Fall 2021

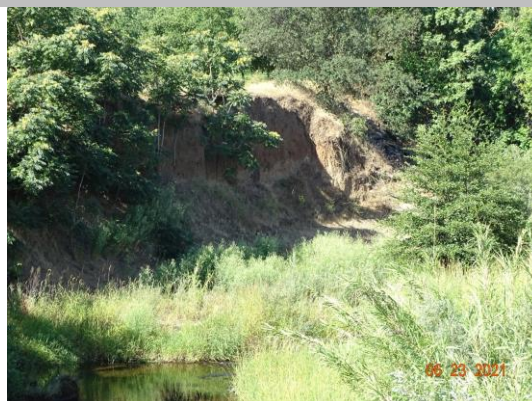
Photo 2 of 3 : SJR2021_NA0017U16RM23.35_3.JPG

6/23/2021: View of the erosion from the opposite bank.

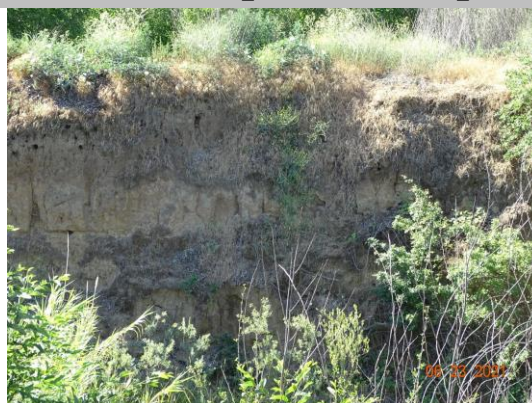
Photo 3 of 3 : SJR2021_NA0017U16RM23.35_5.JPG

6/23/2021: View of the erosion near the downstream end.

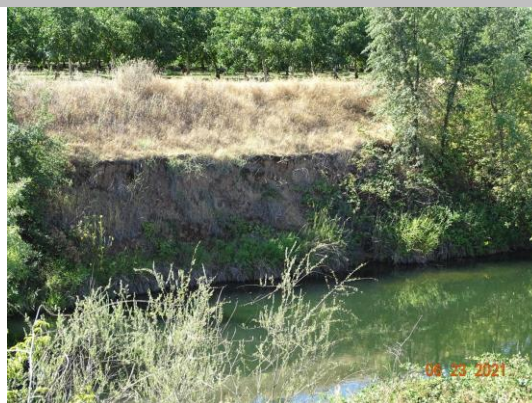
Photo 1 of 1 : SJR2021_NA0017U16RM22.74_3.JPG

LM Start	0.93	Rating **	A/W	Issue No.	11	
LM End	0.96	Issue Type +	Ma	Location *		
Category	Supplemental			GPS Latitude/Longitude		
				Start		End
Item	DWR Erosion Survey			38.042730 °		38.042730 °
				-121.025722 °		-121.025722 °
DWR ID	NA0017U16RM22.74					
Comment Code						
Inspector Comment						
Site ID: NA0017U16RM22.74						
*This area is patrol road only and therefore the site is not rated						
06/23/2021: From 2013 to present, no significant changes were						
observed during the annual survey. The erosion length was updated to						
180 ft based on more accurate field measurements.						
08/22/2012: The erosion was surveyed and documented for monitoring						
purpose. There is no levee structure on the site, only high ground						
protecting the land behind. There is a drainage pipe at the site, which						
might have caused the problem at one pocket erosion.

6/23/2021: View of the erosion from the opposite bank.

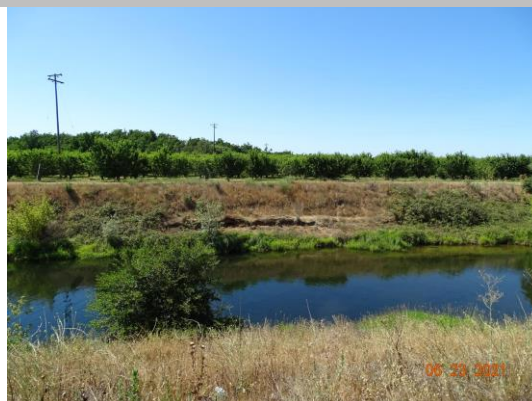
Photo 1 of 2 : SJR2021_NA0017U16RM22.16_1.JPG

LM Start	1.55	Rating **	A/W	Issue No.	4
LM End	1.56	Issue Type +	Ma	Location *	
Category	Supplemental			GPS Latitude/Longitude	
				Start	End
Item	DWR Erosion Survey			38.039394 °	38.039394 °
				-121.035289 °	-121.035289 °
DWR ID	NA0017U16RM22.16				
Comment Code					
Inspector Comment					
Site ID: NA0017U16RM22.16					
*This area is patrol road only and therefore the site is not rated					
06/23/2021: The site was discovered during the field survey. The erosion is just downstream of a weir. There is some caving and sloughing visible on the slope and a large, 1.5-ft long and 0.8-ft wide rodent hole at the toe.

6/23/2021: View of the erosion from the opposite bank.

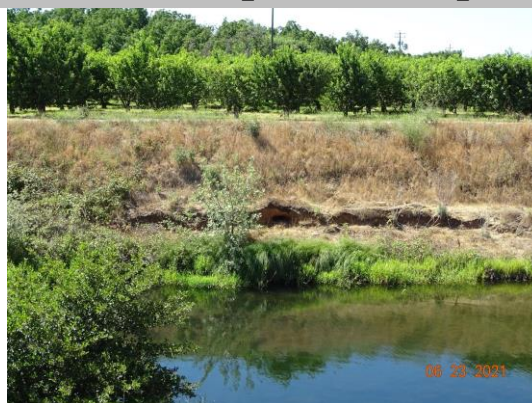
Photo 2 of 2 : SJR2021_NA0017U16RM22.16_2.JPG

6/23/2021: View of the erosion and large animal hole in the center at the toe.

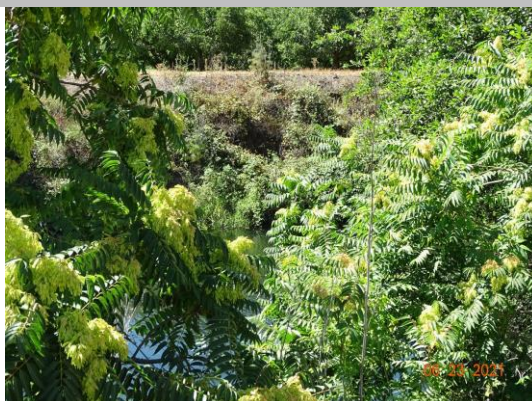
Photo 1 of 2 : SJR2021_NA0017U16RM22.15_1.JPG

*This area is patrol road only and therefore the site is not rated
06/23/2021: From 2013 to present, no significant changes were observed during the annual survey. This site was combined with a site immediately downstream (NA0017U016RM22.01) and the erosion length increased to 40 ft.
08/22/2012: The berm is estimated at 10 ft. Dense vegetation on site. There is no levee structure on site.

6/23/2021: View of the erosion from the opposite bank.

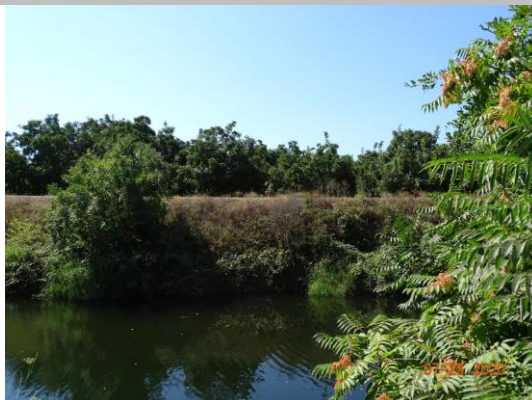
Photo 2 of 2 : SJR2021_NA0017U16RM22.01_02.JPG

7/23/2020: View of the erosion from the opposite bank.

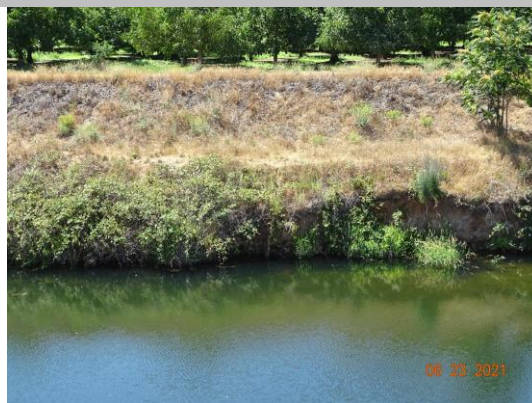
Photo 1 of 2 : SJR2021_NA0017U16RM21.95_2.JPG

LM Start	1.72	Rating **	A/W	Issue No.	18	
LM End	1.78	Issue Type +	Ma	Location *		
Category	Supplemental			GPS Latitude/Longitude		
				Start		End
Item	DWR Erosion Survey			38.038080 °	38.038080 °	
				-121.038676 °	-121.038676 °	
DWR ID	NA0017U16RM21.95					
Comment Code						
Inspector Comment						
Site ID: NA0017U16RM21.95						
*This area is patrol road only and therefore the site is not rated						
06/23/2021: From 2013 to present, no significant changes were						
observed during the annual survey. The scarp is nearly vertical at the						
toe. This site was combined with a site immediately downstream						
(NA0017U16RM21.94) and the erosion length increased to 320 ft.						
08/22/2012: The erosion is covered by dense vegetation. There is no						
levee structure on site.

6/23/2021: View of the erosion from the opposite bank.

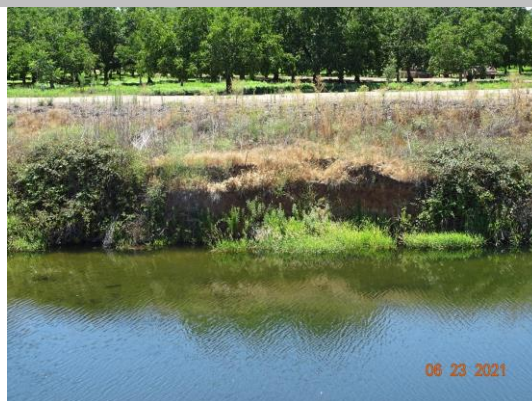
Photo 1 of 2 : SJR2021_NA0017U16RM21.05_1.JPG

06/23/2021: The erosion length was updated to 290 ft based on more accurate field measurements. Otherwise, no significant changes were observed since the previous inspection.

07/23/2020: From 2013 to present, no significant changes were observed during the annual survey. This site was combined with a site immediately downstream (NA0017U16RM21.03). The erosion is just up and downstream of an irrigation pipe crossing (see DSIDs 23321/24938).

6/23/2021: View of the erosion from the opposite bank.

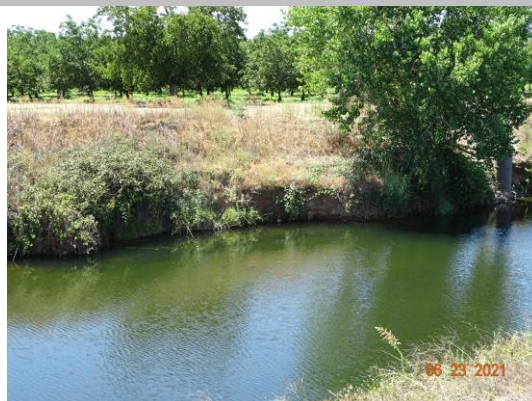
Photo 2 of 2 : SJR2021_NA0017U16RM21.05_2.JPG

6/23/2021: View of the erosion just upstream of the pipe crossing.

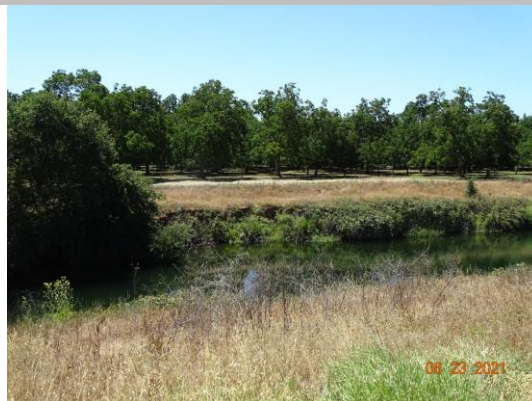
Photo 1 of 1 : SJR2021_NA0017U16RM20.71_1.JPG

LM Start	2.26	Rating **	A/W	Issue No.	22
LM End	2.27	Issue Type +	Ma	Location *	
Category	Supplemental			GPS Latitude/Longitude	
				Start	End
Item	DWR Erosion Survey			38.032670 °	38.032670 °
				-121.044700 °	-121.044700 °
DWR ID	NA0017U16RM20.71				
Comment Code					
Inspector Comment					
Site ID: NA0017U16RM20.71					
*This area is patrol road only and therefore the site is not rated					
06/23/2021: From 2013 to present, no significant changes were					
observed during the annual survey. The erosion length was updated to					
75 ft based on more accurate field measurements.					
08/22/2012: Site is covered with dense vegetation. There is no levee					
structure on site.

6/23/2021: View of the erosion from the opposite bank.

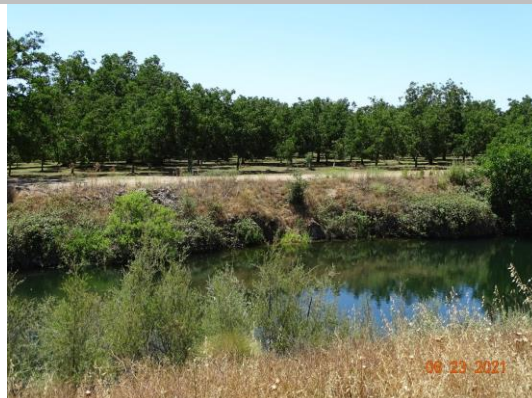
Photo 1 of 2 : SJR2021_NA0017U16RM20.62_1.JPG

LM Start	2.29	Rating **	A/W	Issue No.	37
LM End	2.31	Issue Type +	Ma	Location *	
Category	Supplemental			GPS Latitude/Longitude	
				Start	End
Item	DWR Erosion Survey			38.032202 °	38.032202 °
				-121.045226 °	-121.045226 °
DWR ID	NA0017U16RM20.62				
Comment Code					
Inspector Comment					
Site ID: NA0017U16RM20.62					
*This area is patrol road only and therefore the site is not rated					
06/23/2021: From 2013 to present, no significant changes were					
observed during the annual survey. The erosion length was updated to					
120 ft based on more accurate field measurements.					
08/22/2012: The erosion was first reported in the 2012 spring levee					
inspection report. There is no levee structure on site.

6/23/2021: View of the erosion from the opposite bank.

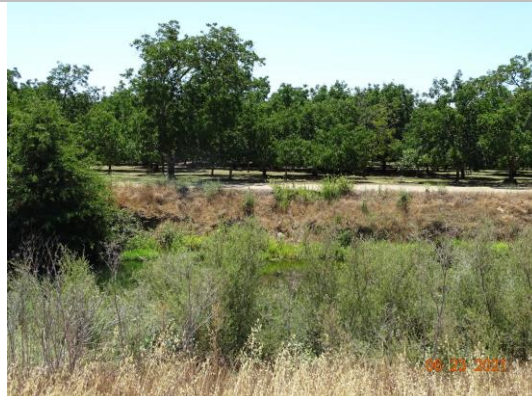
Photo 2 of 2 : SJR2021_NA0017U16RM20.62_3.JPG

6/23/2021: Another view of the erosion from the opposite bank.

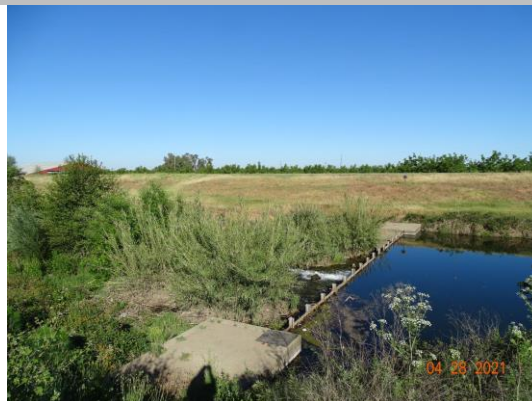
Photo 1 of 1 : FA_2021_NA0017_160_247_20210913_00115.jpg

LM Start	2.44	Rating **	M	Issue No.	247
LM End	2.44	Issue Type +	Ma	Location *	WS
Category	Rivers, Channels & Designated Floodways			GPS Latitude/Longitude	
				Start	End
Item	Vegetation & Obstructions			38.030668 °	38.030668 °
				-121.046842 °	-121.046842 °
DWR ID	DWR_NA0017_16_f_2017_247				
Comment Code					
Inspector Comment					
Arundo in the channel may decrease the capacity of the channel.

View of Arundo within the channel looking downstream. Spring 2021

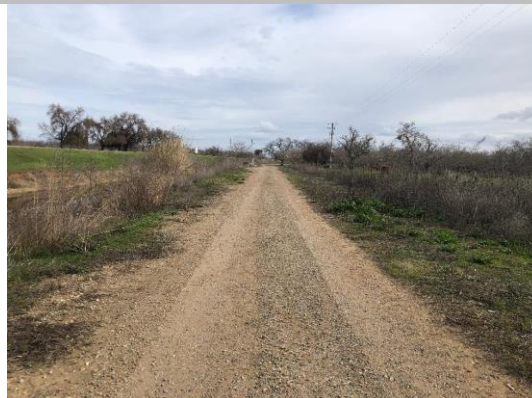
Photo 1 of 3 : UCIP_FA_2021_65963_95459.jpg

Comment Code					
Inspector Comment					
DS_ID:23323 FS_ID:65963 EP_NO: N/A Repair Type: Non-Urgent EVAL Issue: Unauthorized Encroachment, installed decades prior Crossing Status: Found UCIP Comments: 03/09/2021 Record remains Non-Urgent. Unit 16 – Mormon Slough (CLM 0 to 11) is considered a patrol road/high ground area with no defined levee prism, any issue found between CLM 0 to 11 of Unit 16 will be considered a maintenance issue, or an unauthorized encroachment, or an abandoned encroachment. Current condition of pipe crossing does not impede access to patrol road/high ground area. Access limited to pipe inlet due to fencing. Pipe inlet appears bent and partly filled with sediment. Briar bush and vegetation overgrowth limiting visibility of WS slope. No permit has been identified authorizing utility. CVFPB will need to review crossing to determine owner. The UCIP inspection was completed with LMA representative, H. Latu. (N. Cholewinski - GEI)04/24/2014 Heavy vegetation obscuring outlet. remove vegetation and verify flapgate installed. (W. Wylie - DWR UCIP) FIELD_STRUCT_DESC: 18-inch corrugated metal drainage pipe, 3 feet below the roadway. Grouted spillway. [Additional Reference(s): DWR Levee Log, 1992. USACE San Joaquin O&M Manual 611.1, Volume F, (HLM 2.52)]. FS Date: 3/9/2021

Crossing Overview

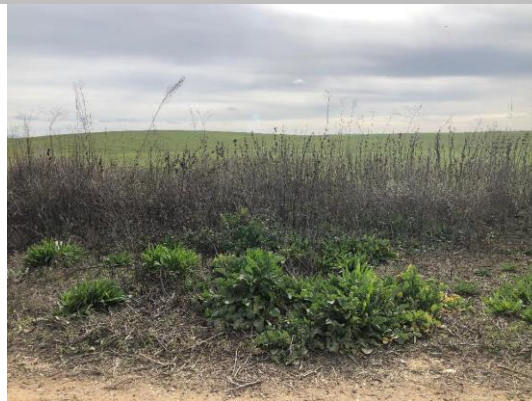
Photo 2 of 3 : UCIP_FA_2021_65963_95460.jpg

LS View

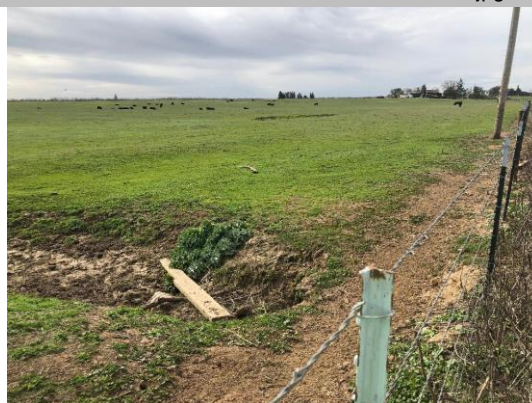
Photo 3 of 3 : UCIP_FA_2021_65963_95461.jpg

LS View: Pipe inlet visible at LS.

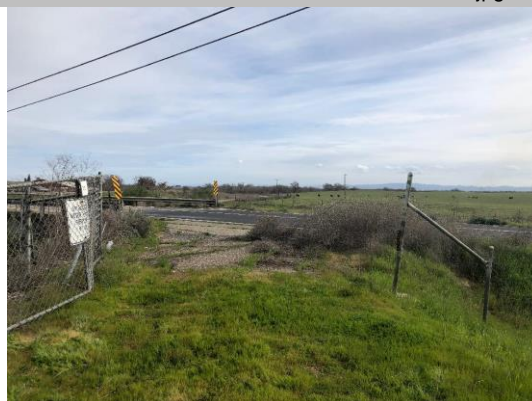
Photo 1 of 3 : UCIP_FA_2021_65964_95452.jpg

DS_ID:23446
FS_ID:65964
EP_NO: N/A
Repair Type: Non-Urgent
EVAL Issue: Unauthorized Encroachment, installed decades prior
Crossing Status: Found
UCIP Comments: 03/09/2021 Record remains Non-Urgent. Unit 16 – Mormon Slough (CLM 0 to 11) is considered a patrol road/high ground area with no defined levee prism, any issue found between CLM 0 to 11 of Unit 16 will be considered a maintenance issue, or an unauthorized encroachment, or an abandoned encroachment. DWR DMP internal video inspection has not found pipe integrity issues. LOF of crossing is less or equal to 4.0. Recommend next video inspection in 5 years. Current condition of pipe crossing does not impede access to patrol road/high ground area. Briar bush overgrowth limiting access and visibility at WS slope. No flapgate at WS. No permit has been identified authorizing utility. CVFPB will need to review crossing to determine owner. The UCIP inspection was completed with LMA representative, H. Latu. (N. Cholewinski - GEI)09/18/2018 Lots of sediment in the inlet: needs to be cleared out. No integrity issues, yet there's dense vegetation and potential flooding risk during high water. Crossing downgraded to "Non-Urgent." (A. McDonald - DWR UCIP)10/31/2016 Same as last inspection. Pipe is open on both ends, no flap gate. (O. Magana - DWR UCIP)04/24/2014 Pipe in non-project levee area. Pipe open on both ends, no flapgate. (W. Wylie - DWR UCIP)

FIELD_STRUCT_DESC: 36-inch corrugated metal drainage culvert through the levee, 10 feet below the crown. Pipe open on both ends.
[Additional Reference(s): USACE San Joaquin O&M Manual Unit 611, Part No. 1 – Mormon Slough Project, Unit 15 Mormon Slough: HLM 1.18 – 13.46, Unit 15 Diverting Canal: HLM 13.79 – 18.01, Unit 15 Calaveras River LB: 18.54-18.76, Unit 15 Calaveras River RB: HLM 19.35 – 25.38, Unit 16 Mormon Slough: 0.27 – 13.18, Unit 16 Diverting Canal: 14.71 – 17.79, Unit 16 Calaveras River: 18.98 – 23.36, Unit 17 Potter Creek RB: 0.33 – 0.60, Unit 18 Potter Creek LB: 0.00-0.55, (HLM 2.82)]
FS Date: 3/9/2021

Crossing Overview

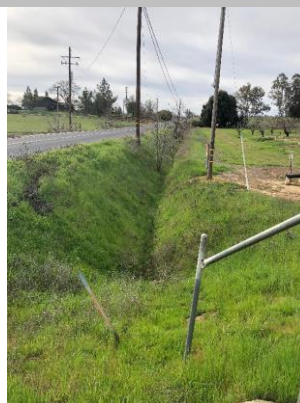
Photo 2 of 3 : UCIP_FA_2021_65964_95453.jpg

LS View: Pipe in drainage ditch at LS.

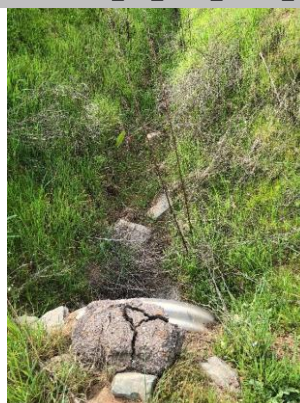
Photo 3 of 3 : UCIP_FA_2021_65964_95454.jpg

LS View: Pipe in drainage ditch at LS.

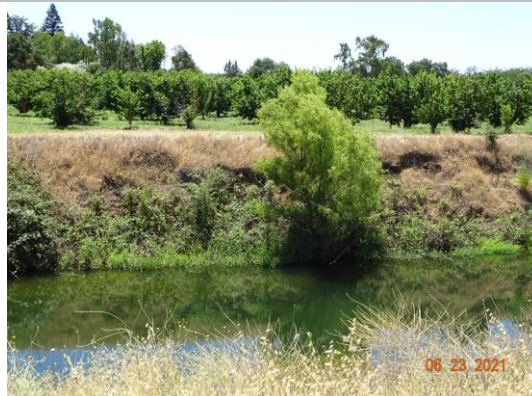
Photo 1 of 2 : SJR2021_NA0017U16RM20_2.JPG

*This area is patrol road only and therefore the site is not rated
06/23/2021: From 2013 to present, no significant changes were observed during the annual survey. The erosion length was updated to 110 ft based on more accurate field measurements.

6/23/2021: View of the erosion from the opposite bank.

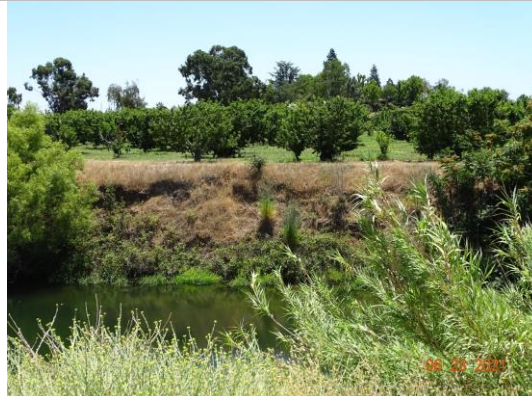
Photo 2 of 2 : SJR2021_NA0017U16RM20_3.JPG

6/23/2021: Another view of the erosion from the opposite bank.

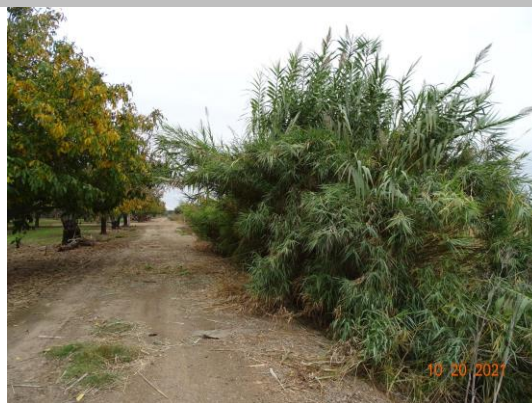
Photo 1 of 1 : FA_2021_NA0017_160_152_20211020_00684.jpg

LM Start	3.47	Rating **	U	Issue No.	152
LM End	3.53	Issue Type +	Ma	Location *	WS
Category	Earthen Levee			GPS Latitude/Longitude	
				Start	End
Item	Vegetation			38.021036 °	38.020402 °
				-121.061101 °	-121.061873 °
DWR ID	DWR_NA0017_16_f_2013_152				
Comment Code					
V2 : Remove the wild growth other than native grasses from the levee slopes.					
Inspector Comment					
Arundo was obstructing the inspection of the channel from the patrol road.

View of Arundo on the waterside shoulder. Fall 2021

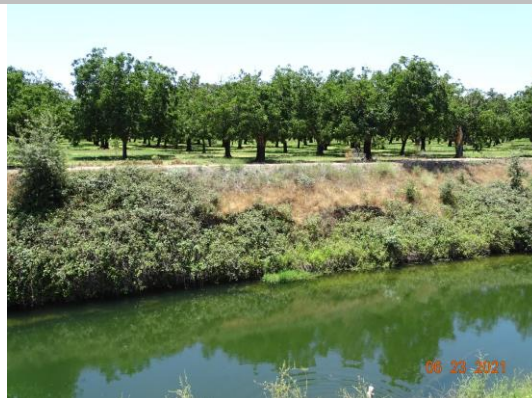
Photo 1 of 1 : SJR2021_NA0017U16RM19.29_1.JPG

LM Start	3.61	Rating **	A/W	Issue No.	41
LM End	3.62	Issue Type +	Ma	Location *	
Category	Supplemental			GPS Latitude/Longitude	
				Start	End
Item	DWR Erosion Survey			38.019642 °	38.019642 °
				-121.062917 °	-121.062917 °
DWR ID	NA0017U16RM19.29				
Comment Code					
Inspector Comment					
Site ID: NA0017U16RM19.29					
*This area is patrol road only and therefore the site is not rated					
06/23/2021: From 2015 to present, no significant changes were					
observed during the annual survey. The erosion length was updated to					
60 ft based on more accurate field measurements.The vegetation					
growth has increased.					
08/20/2014: A pocket erosion was found near the water's edge.

6/23/2021: View of the erosion from the opposite bank.

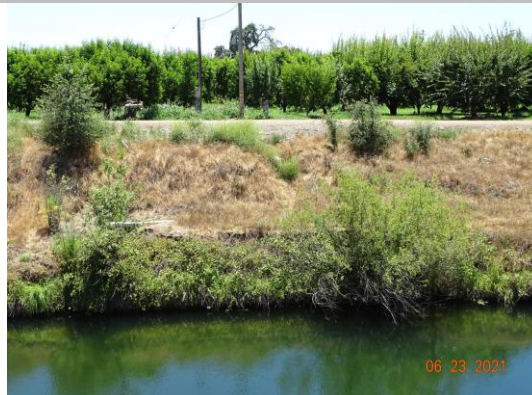
Photo 1 of 1 : SJR2021_NA0017U16RM19.18_1.JPG

LM Start	3.79	Rating **	A/W	Issue No.	25
LM End	3.80	Issue Type +	Ma	Location *	
Category	Supplemental			GPS Latitude/Longitude	
				Start	End
Item	DWR Erosion Survey			38.017715 °	38.017715 °
				-121.065011 °	-121.065011 °
DWR ID	NA0017U16RM19.18				
Comment Code					
Inspector Comment					
Site ID: NA0017U16RM19.18 *This area is patrol road only and therefore the site is not rated 06/23/2021: From 2013 to present, no significant changes were observed during the annual survey. The erosion length was updated to 40 ft based on more accurate field measurements. Vegetation growth has slightly increased. 08/22/2012: River-induced erosion occurred on the berm, while the runoff-induced erosion occurred on the levee slope. Site is covered with vegetation. There is no levee structure on site.

6/23/2021: View of the erosion from the opposite bank.

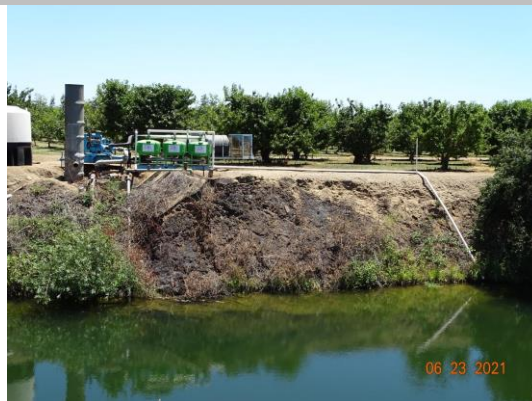
Photo 1 of 1 : SJR2021_NA0017U16RM18.69_1.JPG

Comment Code					
Inspector Comment					
Site ID: NA0017U16RM18.69					
*This area is patrol road only and therefore the site is not rated					
06/23/2021: From 2018 to present, no significant changes were observed during the annual survey. The erosion length was updated to 50 ft based on more accurate field measurements. The slope has been burned recently. The site is located just upstream of an irrigation pipe crossing (DSIDs 23328/24945).					
08/30/2017: New erosion observed at the site, under the irrigation pipe.					
08/16/2016: From 2013 to present, no significant changes were observed during the annual survey.					
08/22/2012: An irrigation pipe is present at the site, but probably did not cause the erosion. There is no levee structure on site.

6/23/2021: View of the erosion and burned slope from the opposite bank.

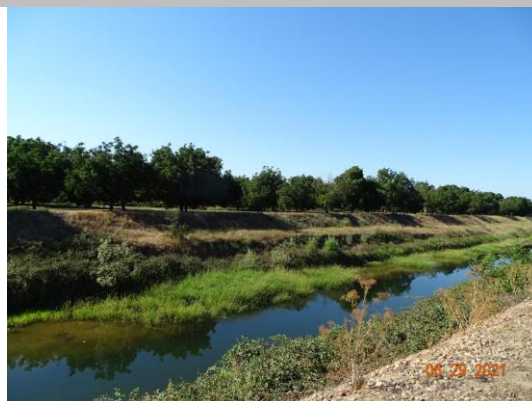
Photo 1 of 2 : SJR2021_NA0017U16RM17.81_1.JPG

LM Start	5.33	Rating **	A/W	Issue No.	29
LM End	5.37	Issue Type +	Ma	Location *	
Category	Supplemental			GPS Latitude/Longitude	
				Start	End
Item	DWR Erosion Survey			37.997720 °	37.997720 °
				-121.077807 °	-121.077807 °
DWR ID	NA0017U16RM17.81				
Comment Code					
Inspector Comment					
Site ID: NA0017U16RM17.81					
*This area is patrol road only and therefore the site is not rated					
06/29/2021: From 2013 to present, no significant changes were					
observed during the annual survey. The erosion length was updated to					
210 ft based on more accurate field measurements.					
08/22/2012: The site is located at the opposite river bank of E. Tobacco					
Road. There is no levee structure on site.

6/29/2021: View of the erosion from the opposite bank.

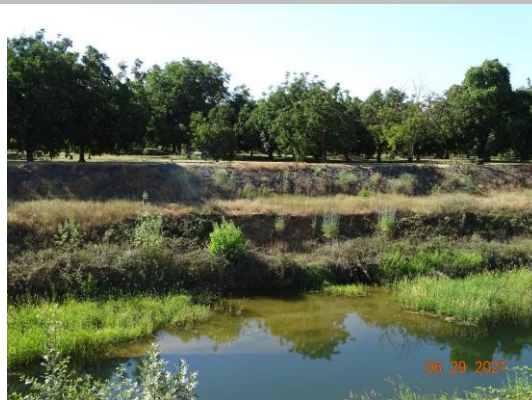
Photo 2 of 2 : SJR2021_NA0017U16RM17.81_2.JPG

6/29/2021: View of the erosion a little further downstream.

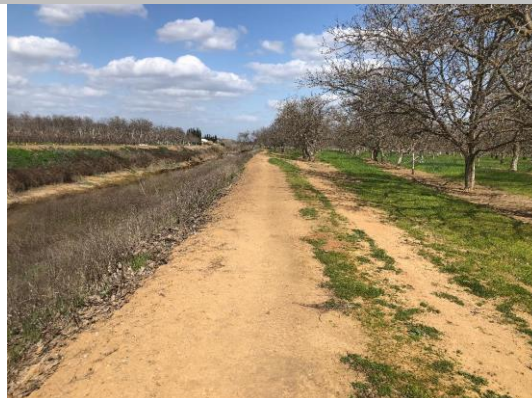
Photo 1 of 3 : UCIP_FA_2021_66029_95182.jpg

Item	DWR UCIP LMA Responsibility		37.996132 °	37.996132 °								
			-121.079127 °	-121.079127 °								
DWR ID	23332											
Comment Code												
Inspector Comment												
DS_ID:23332 FS_ID:66029 EP_NO: N/A Repair Type: Non-Urgent EVAL Issue: Maintenance Compliance Issue Crossing Status: Found UCIP Comments: 03/08/2021 Record remains Non-Urgent. Unit 16 – Mormon Slough (CLM 0 to 11) is considered a patrol road/high ground area with no defined levee prism, any issue found between CLM 0 to 11 of Unit 16 will be considered a maintenance issue, or an unauthorized encroachment, or an abandoned encroachment. DWR DMP internal video inspection has found pipe integrity issues. LOF of crossing is between 5 and 6. Crossing will be monitored until funding becomes available to address the issues. Current condition of pipe crossing does not impede access to patrol road/high ground area. riar bush overgrowth limiting access and visibility on WS. Pipe appears to be deteriorating and severely corroded at the WS toe. Pipe inlet not visible on LS. Small depression visible at LS along alignment, possible location of buried pipe inlet. No permit was found authorizing this encroachment. CVFPB will need to review crossing to determine owner. The UCIP inspection was completed with LMA representative, H. Latu. (N. Cholewinski - GEI)04/30/2014 Pipe appears abandoned and if so should be done so properly. LS of pipe is buried and WS is badly rusted. Pipe should be inspected internally. (W. Wylie - DWR UCIP) FIELD_STRUCT_DESC: 18-inch corrugated metal drainage pipe through the levee, 3 feet below the crown. Grout over pipe in channel with pipe open and visible in water at the WS toe. [Additional Reference(s): DWR Levee Log, 1992. USACE San Joaquin O&M Manual 611.1, Volume F, (HLM 5.69)]. FS Date: 3/8/2021

Crossing Overview

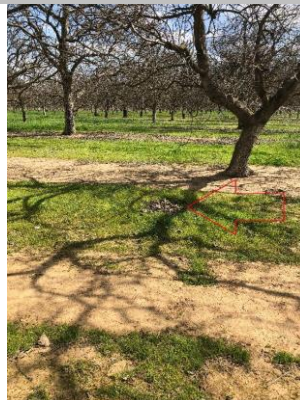
Photo 2 of 3 : UCIP_FA_2021_66029_95183.jpg

LS View: Small depression visible at LS.

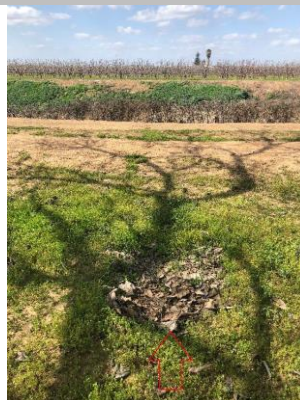
Photo 3 of 3 : UCIP_FA_2021_66029_95184.jpg

LS View: Small depression visible at LS.

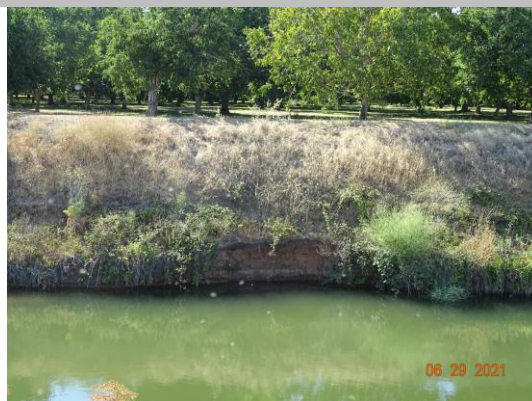
Photo 1 of 2 : SJR2021_NA0017U16RM17.27_3.JPG

*This area is patrol road only and therefore the site is not rated
06/29/2021: From 2014 to present, no significant changes were observed during the annual survey. The erosion is visible in three locations.

09/12/2013: The erosion seems to be caused by high river flow. Dense vegetation is present at the site. Signs of animal activities are visible. There is no levee structure on site.

6/29/2021: View of the erosion from the opposite bank.

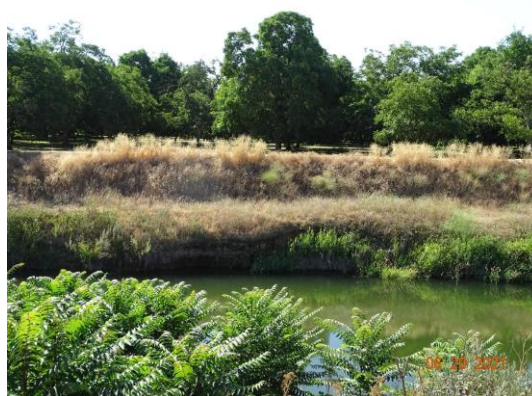
Photo 2 of 2 : SJR2021_NA0017U16RM17.27_4.JPG

6/29/2021: View of the erosion a little further downstream.

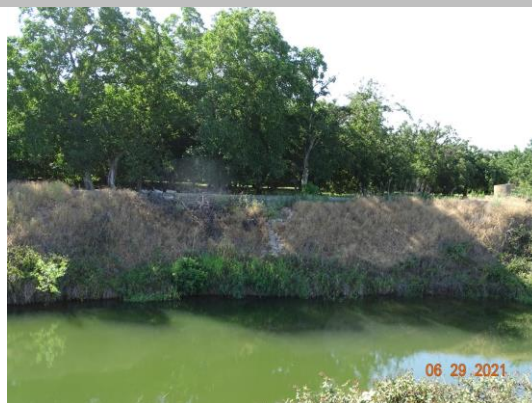
Photo 1 of 2 : SJR2021_NA0017U016RM17.11_1.JPG

LM Start	5.70	Rating **	A/W	Issue No.	42	
LM End	5.72	Issue Type +	Ma	Location *		
Category	Supplemental			GPS Latitude/Longitude		
				Start	End	
Item	DWR Erosion Survey			37.993525	°	37.993525
				-121.081679	°	-121.081679
DWR ID	NA0017U16RM17.11					
Comment Code						
Inspector Comment						
Site ID: NA0017U16RM17.11						
*This area is patrol road only and therefore the site is not rated						
06/29/2021: From 2015 to present, no significant changes were						
observed during the annual survey. The erosion is covered by dense						
vegetation. The erosion length was updated to 95 ft based on more						
accurate field measurements.						
08/20/2014: The erosion is near a tree and probably has been made						
worse by the unstable bank slope.

6/29/2021: View of the erosion from the opposite bank.

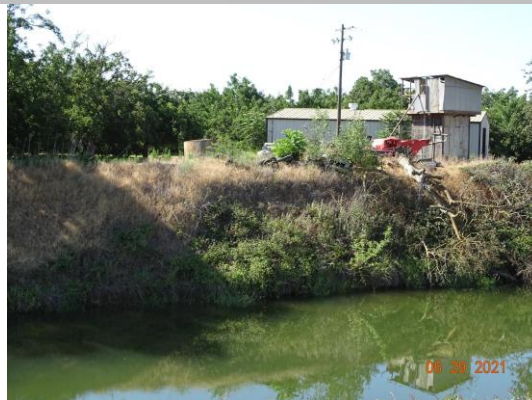
Photo 2 of 2 : SJR2021_NA0017U016RM17.11_2.JPG

6/29/2021: View of the erosion a little further downstream.

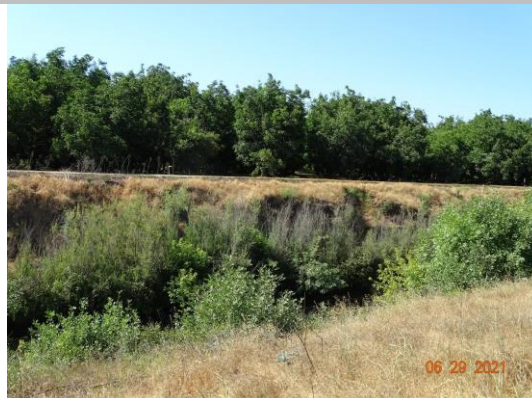
Photo 1 of 2 : SJR2021_NA0017U16RM16.27_1.JPG

*This area is patrol road only and therefore the site is not rated
06/29/2021: From 2014 to present, no significant changes were observed during the annual survey. Noticed several locations with signs of burrowing activity near the downstream end of the erosion site. The erosion length was updated to 600 ft based on more accurate field measurements.

6/29/2021: View of the erosion from the opposite bank.

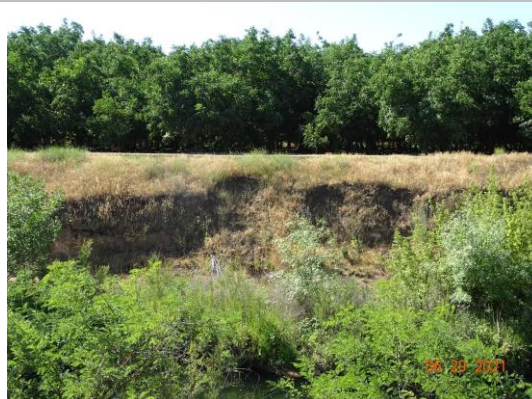
Photo 2 of 2 : SJR2021_NA0017U16RM16.27_5.JPG

6/29/2021: Another view of the erosion from the opposite bank.

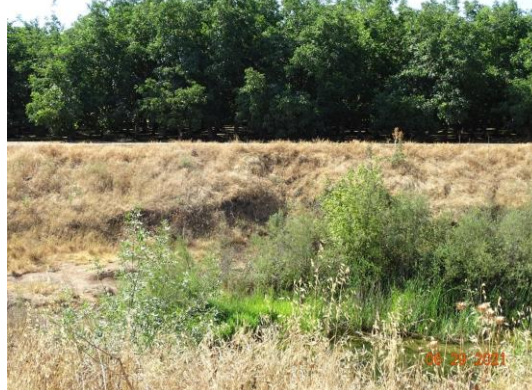
Photo 1 of 2 : SJR2021_NA0017U16RM16.15_1.JPG

LM Start	6.70	Rating **	A/W	Issue No.	43
LM End	6.71	Issue Type +	Ma	Location *	
Category	Supplemental			GPS Latitude/Longitude	
				Start	End
Item	DWR Erosion Survey			37.982299 °	37.982299 °
				-121.092665 °	-121.092665 °
DWR ID	NA0017U16RM16.15				
Comment Code					
Inspector Comment					
Site ID: NA0017U16RM16.15 *This area is patrol road only and therefore the site is not rated 06/29/2021: From 2020 to present, no changes were observed during the annual survey. 08/29/2019: There is no levee at the site. The erosion is likely caused by the rainfall runoff.					
LM Start	6.70	Rating **	A/W	Issue No.	43 (cont)
LM End	6.71	Issue Type +	Ma	Location *

6/29/2021: View of the erosion from the opposite bank.

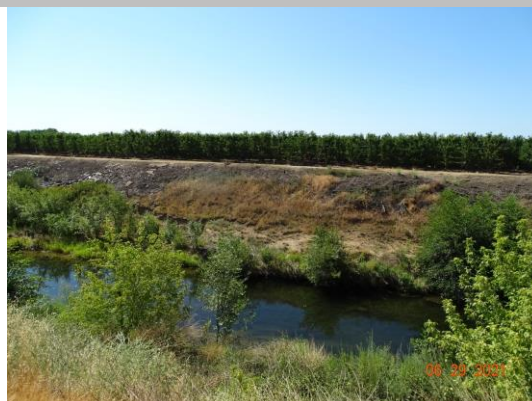
Photo 1 of 2 : SJR2021_NA0017U16RM15.57_1.JPG

*This area is patrol road only and therefore the site is not rated
06/29/2021: From 2014 to present, no significant changes were observed during the annual survey. The erosion length was updated to 80 ft based on more accurate field measurements. The site ID changed from NA0017U16RM10.82 to NA0017U16RM15.57 in 2014 to reflect the correct river mile.

09/12/2013: The site is located at immediately downstream of a levee segment protected by broken concrete. There is no levee structure on site.

6/29/2021: View of the erosion from the opposite bank.

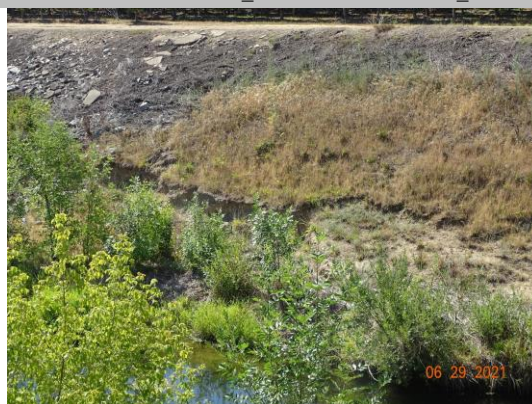
Photo 2 of 2 : SJR2021_NA0017U16RM15.57_2.JPG

6/29/2021: Close-up view of the erosion.

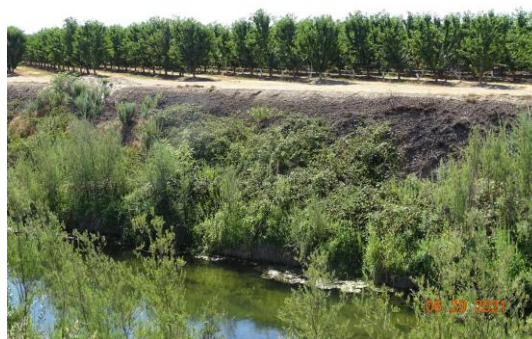
Photo 1 of 2 : SJR2021_NA0017U16RM15.45_3.JPG

*This area is patrol road only and therefore the site is not rated
06/29/2021: The erosion length was updated to 90 ft based on more accurate field measurements. Otherwise, no significant changes were observed since the previous inspection.

6/29/2021: View of the erosion from the opposite bank.

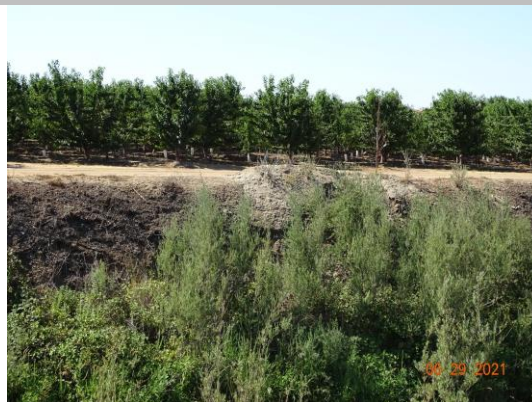
Photo 2 of 2 : SJR2021_NA0017U16RM15.45_2.JPG

6/29/2021: Close-up view of the eroding fill.

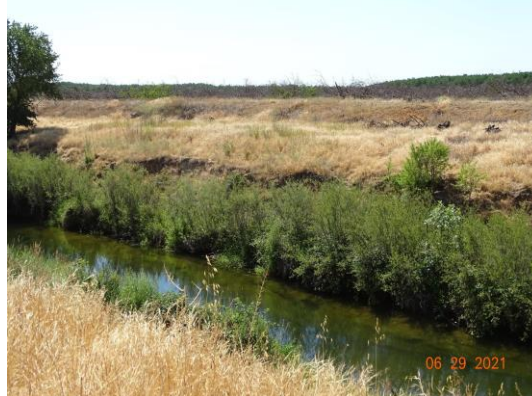
Photo 1 of 2 : SJR2021_NA0017U16RM14.48_1.JPG

LM Start	8.35	Rating **	A/W	Issue No.	31	
LM End	8.37	Issue Type +	Ma	Location *		
Category	Supplemental			GPS Latitude/Longitude		
				Start	End	
Item	DWR Erosion Survey			37.969213 °	37.969213 °	
				-121.116574 °	-121.116574 °	
DWR ID	NA0017U16RM14.48					
Comment Code						
Inspector Comment						
Site ID: NA0017U16RM14.48						
*This area is patrol road only and therefore the site is not rated						
06/29/2021: From 2013 to present, no significant changes were						
observed during the annual survey. The erosion length was updated to						
130 ft based on more accurate field measurements.						
08/22/2012: The erosion occurred on a berm of approximately 25 ft.						
wide. Site is covered with dense vegetation. There is no levee structure						
on site.

6/29/2021: View of the erosion from the opposite bank.

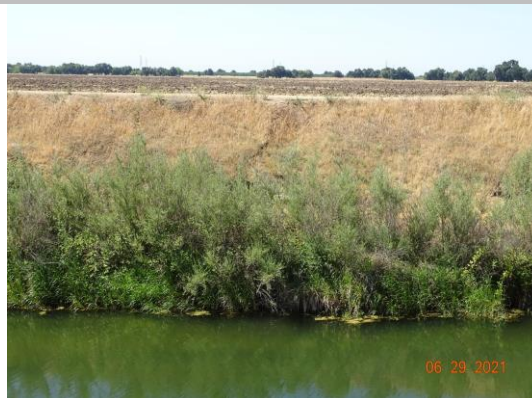
Photo 1 of 2 : SJR2021_NA0017U16RM13.85_1.JPG

LM Start	9.00	Rating **	A/W	Issue No.	40
LM End	9.01	Issue Type +	Ma	Location *	
Category	Supplemental			GPS Latitude/Longitude	
				Start	End
Item	DWR Erosion Survey			37.966585 °	37.966585 °
				-121.127388 °	-121.127388 °
DWR ID	NA0017U16RM13.85				
Comment Code					
Inspector Comment					
Site ID: NA0017U16RM13.85					
*This area is patrol road only and therefore the site is not rated					
06/29/2021: From 2014 to present, no significant changes were					
observed during the annual survey.					
09/12/2013: The erosion might have been caused by river flow					
combined with runoff. Dense vegetation is presents at the site. There is					
no levee structure on site.

6/29/2021: View of the erosion from the opposite bank.

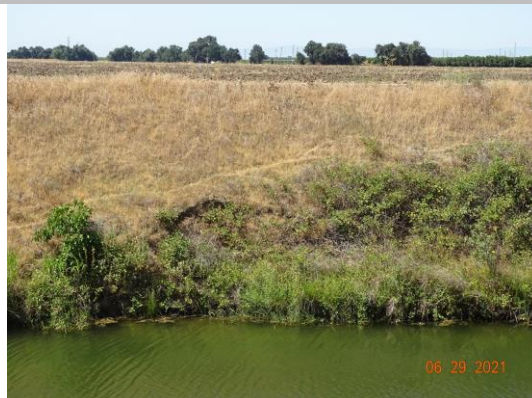
Photo 1 of 1 : SJR2021_NA0017U16RM13.83_2.JPG

LM Start	9.02	Rating **	A/W	Issue No.	47
LM End	9.03	Issue Type +	Ma	Location *	
Category	Supplemental			GPS Latitude/Longitude	
				Start	End
Item	DWR Erosion Survey			37.966639 °	37.966639 °
				-121.127716 °	-121.127716 °
DWR ID	NA0017U16RM13.83				
Comment Code					
Inspector Comment					
Site ID: NA0017U16RM13.83					
*This area is patrol road only and therefore the site is not rated					
06/29/2021: No significant changes were observed since the previous inspection.					
07/24/2020: The site was discovered during the 2020 field survey. The erosion has cut into the bank. Medium to dense vegetation is covering the scarp and slope.

6/29/2021: View of the erosion from the opposite bank.

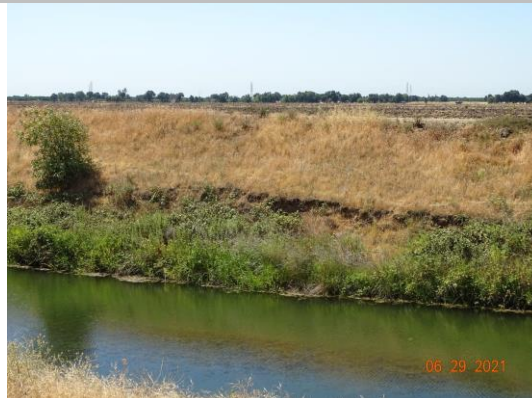
Photo 1 of 1 : SJR2021_NA0017U16RM13.72_2.JPG

LM Start	9.11	Rating **	A/W	Issue No.	33
LM End	9.13	Issue Type +	Ma	Location *	
Category	Supplemental			GPS Latitude/Longitude	
				Start	End
Item	DWR Erosion Survey			37.966922 °	37.966922 °
				-121.129533 °	-121.129533 °
DWR ID	NA0017U16RM13.72				
Comment Code					
Inspector Comment					
Site ID: NA0017U16RM13.72					
*This area is patrol road only and therefore the site is not rated					
06/29/2021: From 2013 to present, no significant changes were					
observed during the annual survey. The erosion length was updated to					
110 ft based on more accurate field measurements.					
08/22/2012: The erosion is covered with dense vegetation. There is no					
levee structure on site.

6/29/2021: View of the erosion from the opposite bank.

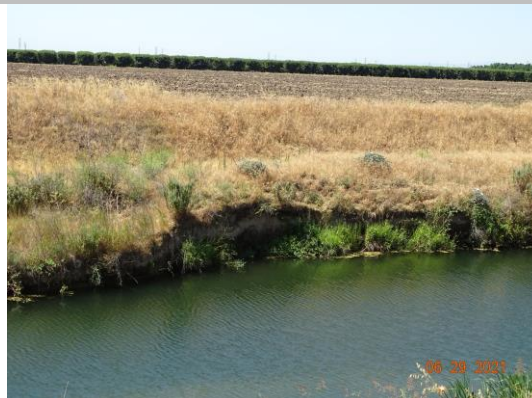
Photo 1 of 2 : SJR2021_NA0017U16RM13.53_2.JPG

LM Start	9.31	Rating **	A/W	Issue No.	34
LM End	9.33	Issue Type +	Ma	Location *	
Category	Supplemental			GPS Latitude/Longitude	
				Start	End
Item	DWR Erosion Survey			37.966772 °	37.966772 °
				-121.133071 °	-121.133071 °
DWR ID	NA0017U16RM13.53				
Comment Code					
Inspector Comment					
Site ID: NA0017U16RM13.53					
*This area is patrol road only and therefore the site is not rated					
06/29/2021: From 2013 to present, no significant changes were					
observed during the annual survey. The erosion length was updated to					
130 ft based on more accurate field measurements.					
08/22/2012: The erosion is on berm. The berm width is estimated.					
There is no levee structure on site.

6/29/2021: View of the erosion from the opposite bank.

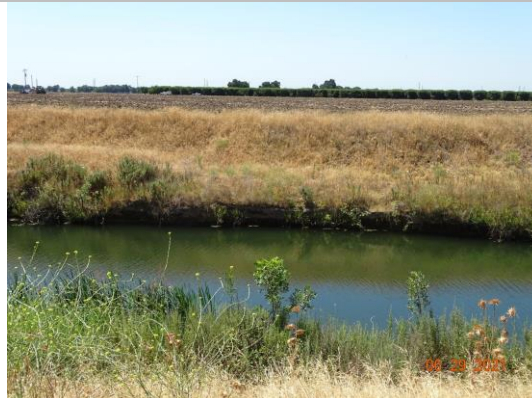
Photo 2 of 2 : SJR2021_NA0017U16RM13.53_3.JPG

6/29/2021: View of the erosion a little further downstream.

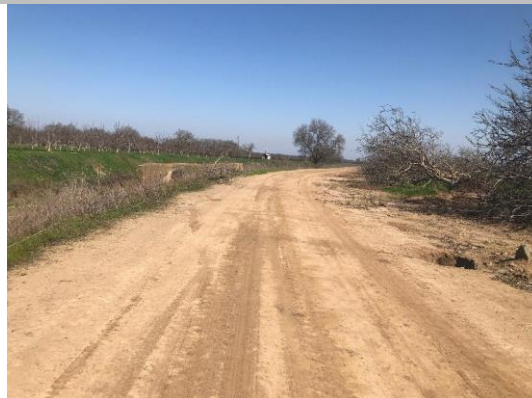
Photo 1 of 3 : UCIP_FA_2021_65879_94889.jpg

Comment Code					
Inspector Comment					
DS_ID:23344 FS_ID:65879 EP_NO: N/A Repair Type: Non-Urgent EVAL Issue: Maintenance Compliance Issue Crossing Status: Found UCIP Comments: 03/04/2021 Record status is still Non-Urgent. Unit 16 – Mormon Slough (CLM 0 to 11) is considered a patrol road/high ground area with no defined levee prism, any issue found between CLM 0 to 11 of Unit 16 will be considered a maintenance issue, or an unauthorized encroachment, or an abandoned encroachment. DMP internal video inspection has found pipe integrity issues. LOF of crossing is between 4.1 and 5. Crossing will be monitored until funding becomes available for rehabilitation. CM pipe is rusty and bent at LS opening. Observed a 2.5-inch PVC pipe discharging at LS pipe opening. Pipe is severely corroded at the WS toe. The metal is thinned, brittle, and peeling off from the pipe walls. Current condition of pipe crossing does not impede access to patrol road/high ground area. No permit was found authorizing this encroachment. CVFPB will need to review crossing to determine owner. The UCIP inspection was completed with LMA representative, H. Latu. (N. Cholewinski - GEI)04/30/2014 Inlet appears to be burried with soil on LS. Pipe heavily corroded at outlet on WS toe. Good candidate for video inspection. (W. Wylie - DWR UCIP) FIELD_STRUCT_DESC: 18-inch corrugated metal drainage pipe, 3.5 feet below the roadway. Grouted spillway and inlet. [Additional Reference(s): DWR Levee Log, 1992. USACE San Joaquin O&M Manual 611.1, Volume F, (HLM 9.77)]. FS Date: 3/4/2021

Crossing Overview

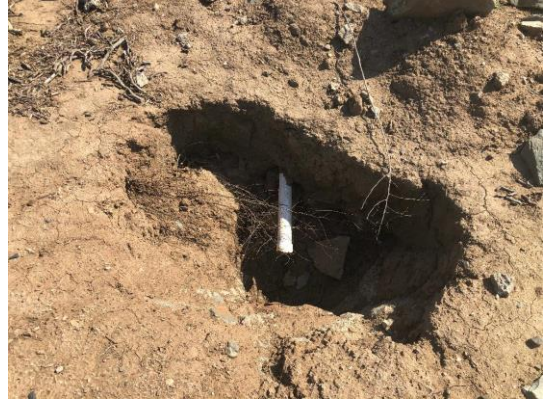
Photo 2 of 3 : UCIP_FA_2021_65879_94890.jpg

LS View: PVC pipe discharging at LS pipe opening.
