**Flood Control Project Maintenance
Levee Inspections**

Maintenance Issue Types Only, Levee Inspection Report By Mile - Fall 2021

San Joaquin County Flood Control and Water Conservation District

Waterway	Bank	Unit Miles	Inspection Start/End	Inspector
Unit No. 01 Littlejohn Creek	Left	2.59	10/21/2021 10/21/2021	Alberto De Leon

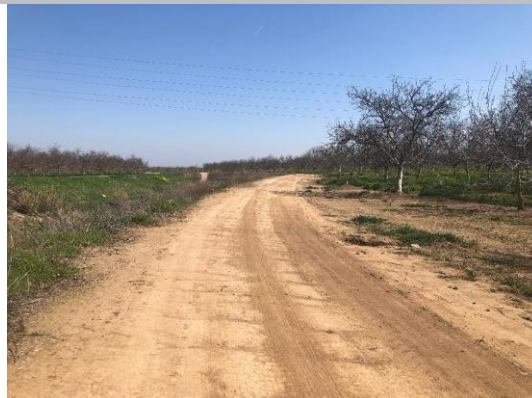
Photo 1 of 3 : UCIP_FA_2021_65881_94882.jpg

Comment Code						
Inspector Comment						
DS_ID:23345 FS_ID:65881 EP_NO: N/A Repair Type: Non-Urgent EVAL Issue: Maintenance Compliance Issue Crossing Status: Found UCIP Comments: 03/04/2021 Record remains Non-Urgent. Unit 16 – Mormon Slough (CLM 0 to 11) is considered a patrol road/high ground area with no defined levee prism, any issue found between CLM 0 to 11 of Unit 16 will be considered a maintenance issue, or an unauthorized encroachment, or an abandoned encroachment. DMP internal video inspection has found pipe integrity issues. LOF of crossing is between 5 and 6. Crossing will be monitored until funding becomes available to address the issues. CM pipe is bent and deformed with visible gaps at the LS pipe opening. Pipe appears rusty and weathered on WS. Current condition of pipe crossing does not impede access to patrol road/high ground area. No permit was found authorizing this encroachment. CVFPB will need to review crossing to determine owner. The UCIP inspection was completed with LMA representative, H. Latu. (N. Cholewinski - GEI)04/30/2014 Inlet on LS buried in soil. (W. Wylie - DWR UCIP) FIELD_STRUCT_DESC: 18-inch corrugated metal drainage pipe through the levee, 3.5 feet below the crown. Grouted spillway and inlet. [Additional Reference(s): DWR Levee Log, 1992. USACE San Joaquin O&M Manual 611.1, Volume F, (HLM 10.07)]. FS Date: 3/4/2021

Crossing Overview

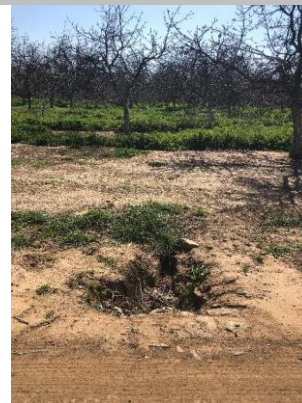
Photo 2 of 3 : UCIP_FA_2021_65881_94883.jpg

LS View: Pipe damaged at LS.

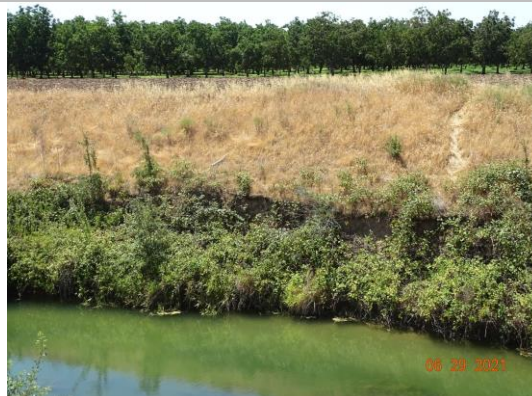
Photo 2 of 2 : SJR2021_NA0017U16RM12.95_3.JPG

LM Start	9.86	Rating **	A/W	Issue No.	36 (cont)
LM End	9.88	Issue Type +	Ma	Location *	
Category	Supplemental			GPS Latitude/Longitude	
				Start	End
Item	DWR Erosion Survey			37.964735 °	37.964735 °
				-121.142503 °	-121.142503 °
DWR ID	NA0017U16RM12.95

6/29/2021: Close-up view of the erosion.

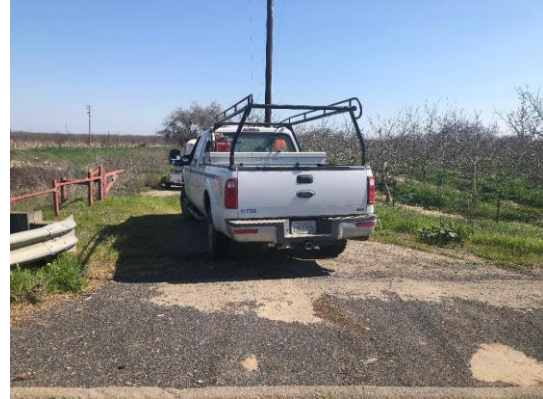
Photo 1 of 3 : UCIP_FA_2021_65884_94863.jpg

Comment Code						
Inspector Comment						
DS_ID:23347 FS_ID:65884 EP_NO: N/A Repair Type: Non-Urgent EVAL Issue: Maintenance Compliance Issue Crossing Status: Found UCIP Comments: 03/04/2021 Record remains Non-Urgent. Unit 16 – Mormon Slough (CLM 0 to 11) is considered a patrol road/high ground area with no defined levee prism, any issue found between CLM 0 to 11 of Unit 16 will be considered a maintenance issue, or an unauthorized encroachment, or an abandoned encroachment. DMP internal video inspection has found pipe integrity issues. LOF of crossing is between 5 and 6. Crossing will be monitored until funding becomes available to address the issues. Limited access to and briar bush overgrowth on WS. Pipe is corroding and rusty at LS. Current condition of pipe crossing does not impede access to patrol road/high ground area. No permit was found authorizing this encroachment. CVFPB will need to review crossing to determine owner. The UCIP inspection was completed with LMA representative, H. Latu. (N. Cholewinski - GEI)04/30/2014 Heavy sediment buildup at inlet on LS toe. (W. Wylie - DWR UCIP) FIELD_STRUCT_DESC: 18-inch corrugated metal drainage pipe through the levee, 5.5 feet below the crown. Concrete U-shaped headwall on the landside (LS). Flap gate on the waterside (WS) end. [Additional Reference(s): DWR Levee Log, 1992. USACE San Joaquin O&M Manual 611.1, Volume F, (HLM 10.50)]. FS Date: 3/4/2021

Crossing Overview

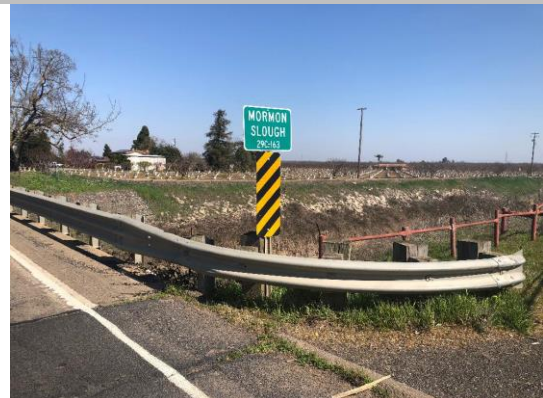
Photo 2 of 3 : UCIP_FA_2021_65884_94864.jpg

WS View

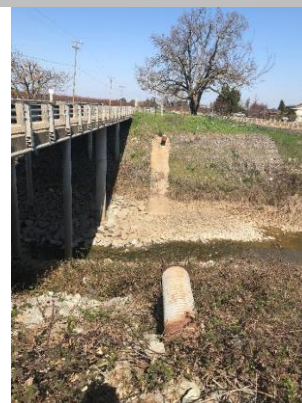
Photo 3 of 3 : UCIP_FA_2021_65884_94865.jpg

WS View: Pipe and flapgate at WS slope. Briar bush overgrowth present.

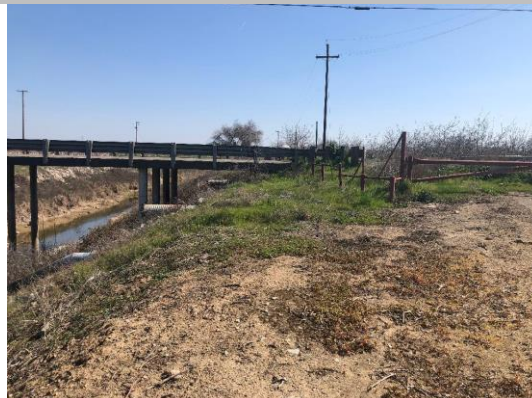
Photo 1 of 3 : UCIP_FA_2021_65887_94853.jpg

Comment Code					
Inspector Comment					
DS_ID:23348 FS_ID:65887 EP_NO: N/A Repair Type: Non-Urgent EVAL Issue: Maintenance Compliance Issue Crossing Status: Found UCIP Comments: 03/04/2021 Record was updated from No Action Needed to Non-Urgent. Unit 16 – Mormon Slough (CLM 0 to 11) is considered a patrol road/high ground area with no defined levee prism, any issue found between CLM 0 to 11 of Unit 16 will be considered a maintenance issue, or an unauthorized encroachment, or an abandoned encroachment. DWR DMP has found integrity issues, LOF between 4 and 5. Crossing will be monitored until funding becomes available for rehabilitation. Current condition of pipe crossing does not impede access to patrol road/high ground area. No permit was found authorizing this encroachment. CVFPB will need to review crossing to determine owner. The UCIP inspection was completed with LMA representative, H. Latu. (N. Cholewinski - GEI) FIELD_STRUCT_DESC: 18-inch corrugated metal drainage pipe through the levee, 6 feet below the crown. Concrete headwall on the landside (LS). Flap gate on the waterside (WS). [Additional Reference(s): DWR Levee Log, 1992. USACE San Joaquin O&M Manual 611.1, Volume F, (HLM 10.51)]. FS Date: 3/4/2021

Crossing Overview

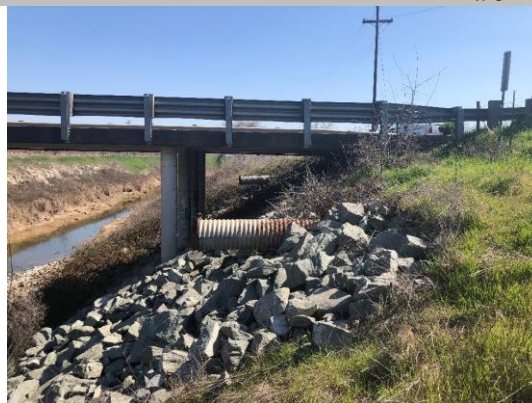
Photo 2 of 3 : UCIP_FA_2021_65887_94854.jpg

WS View: Pipe and flapgate at WS slope.

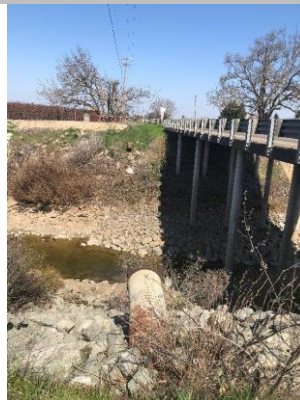
Photo 3 of 3 : UCIP_FA_2021_65887_94855.jpg

WS View: Pipe and flapgate at WS slope.

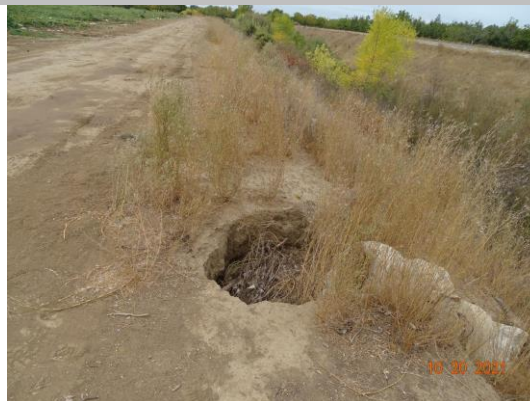
Photo 1 of 1 : FA_2021_NA0017_160_288_20211020_00691.jpg

LM Start	10.57	Rating **	M	Issue No.	288
LM End	10.57	Issue Type +	Ma	Location *	WS
Category	Earthen Levee			GPS Latitude/Longitude	
				Start	End
Item	Erosion / Bank Caving			37.963542 °	37.963542 °
				-121.155111 °	-121.155111 °
DWR ID	DWR_NA0017_16_f_2019_288				
Comment Code					
E2 : Schedule repair of erosion site prior to the next inspection.					
Inspector Comment					
Erosion may cut into patrol access road.

View of erosion on the waterside shoulder. Fall 2021

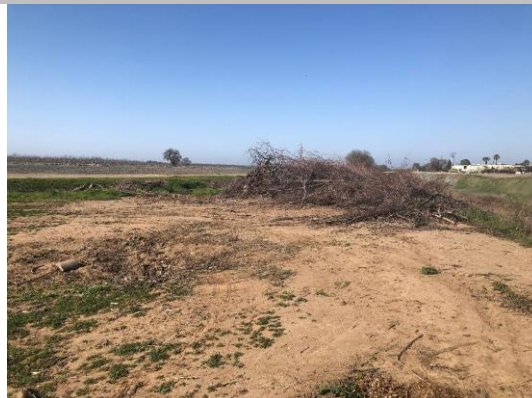
Photo 1 of 3 : UCIP_FA_2021_63857_94805.jpg

Comment Code						
Inspector Comment						
DS_ID:23354 FS_ID:63857 EP_NO: N/A Repair Type: Non-Urgent EVAL Issue: Pipe Damage Crossing Status: Found UCIP Comments: 03/04/2021 Record was updated from No Action Needed to Non-Urgent. DWR DMP has found integrity issues, LOF between 4 and 5. Crossing will be monitored until funding becomes available for rehabilitation. No permit was found authorizing this encroachment. CVFPB will need to review crossing to determine owner. Soil accumulation and concrete debris near LS pipe opening. No visual of pipe at WS grout apron. The UCIP inspection was completed with LMA representative, H. Latu. (N. Cholewinski - GEI) FIELD_STRUCT_DESC: 18-inch corrugated metal drainage pipe through the levee, 3.5 feet below the roadway. Grouted spillway. [Additional Reference(s): DWR Levee Log, 1992. USACE San Joaquin O&M Manual 611.1, Volume F, (HLM 11.41)]. FS Date: 3/4/2021

Crown Overview

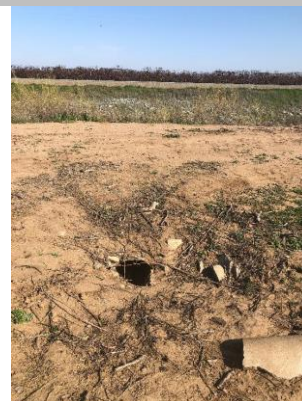
Photo 2 of 3 : UCIP_FA_2021_63857_94806.jpg

LS View: Soil accumulation and concrete debris at pipe opening.

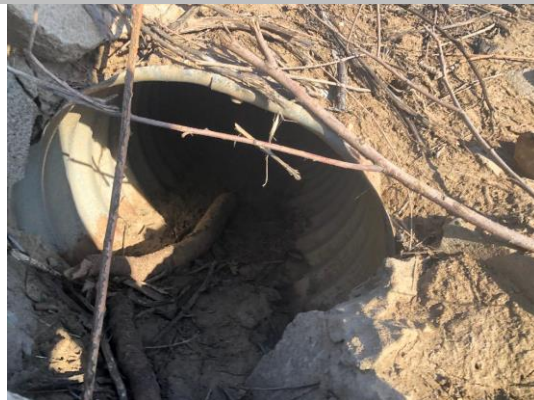
Photo 3 of 3 : UCIP_FA_2021_63857_94807.jpg

LS View: Pipe opening at LS.

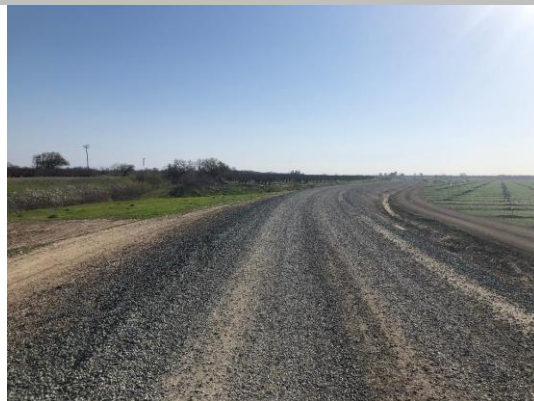
Photo 1 of 3 : UCIP_FA_2021_65153_94795.jpg

LM Start	11.15	Rating **	U	Issue No.	398
LM End	11.15	Issue Type +	Ma	Location *	
Category	Supplemental			GPS Latitude/Longitude	
				Start	End
Item	DWR UCIP LMA Responsibility			37.960322 °	37.960322 °
				-121.164400 °	-121.164400 °
DWR ID	23355

Crown Overview

Comment Code					
Inspector Comment					
DS_ID:23355 FS_ID:65153 EP_NO: N/A Repair Type: Urgent EVAL Issue: Pipe Integrity Crossing Status: Found UCIP Comments: 03/04/2021 Record was updated from No Action Needed to Urgent. DWR DMP has found integrity issues, LOF between 5 and 6. Crossing will be monitored until funding becomes available to be addressed. No permit was found authorizing this encroachment. CVFPB will need to review crossing to determine owner. Flapgate on WS appears misaligned at collar by approximately 1-inch. The UCIP inspection was completed with LMA representative, H. Latu. (N. Cholewinski - GEI) FIELD_STRUCT_DESC: 30-inch steel drainage pipe through the levee, 6 feet below the crown. Concrete U-shaped headwall on both ends. Flap gate on the waterside (WS) end. Grouted inlet and outlet. [Additional Reference(s): DWR Levee Log, 1992. USACE San Joaquin O&M Manual 611.1, Volume F, (HLM 11.45) corrugated metal pipe listed]. FS Date: 3/4/2021

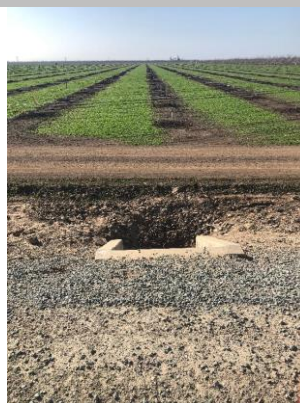
Photo 2 of 3 : UCIP_FA_2021_65153_94796.jpg

LS View: Headwall at LS toe.

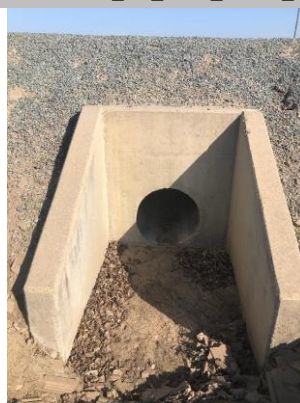
Photo 3 of 3 : UCIP_FA_2021_65153_94797.jpg

LS View: Headwall at LS toe.

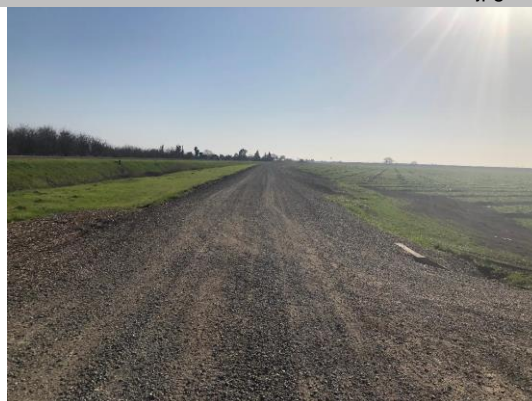
Photo 1 of 3 : UCIP_FA_2021_63851_94767.jpg

Comment Code						
Inspector Comment						
DS_ID:23385 FS_ID:63851 EP_NO: N/A Repair Type: Non-Urgent EVAL Issue: Unauthorized Encroachment, installed decades prior Crossing Status: Found UCIP Comments: 03/04/2021 Record was updated from No Action Needed to Non-Urgent. No permit was found authorizing this encroachment. CVFPB will need to review crossing to determine owner. Observed a 4.5-inch PVC pipe discharging at headwall on LS. Flapgate on WS has single bullet hole. The UCIP inspection was completed with LMA representative, H. Latu. (N. Cholewinski - GEI) FIELD_STRUCT_DESC: 30-inch corrugated metal drainage pipe through the levee, 5.5 feet below the crown. Concrete U-shaped headwall on both ends. Grouted inlet and outlet. Flap gate on the waterside (WS) end. [Additional Reference(s): DWR Levee Log, 1992. USACE San Joaquin O&M Manual 611.1, Volume F, (HLM 12.24)]. FS Date: 3/4/2021

Crown Overview

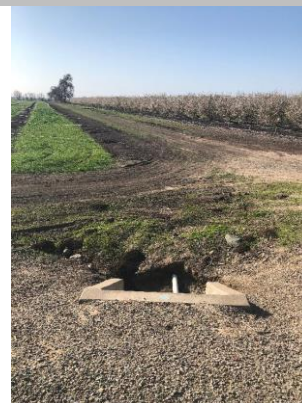
Photo 2 of 3 : UCIP_FA_2021_63851_94768.jpg

LS View: Headwall at LS toe.

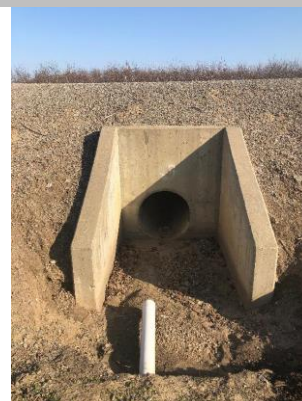
Photo 3 of 3 : UCIP_FA_2021_63851_94769.jpg

LS View: Headwall at LS toe. PVC pipe discharging at headwall.

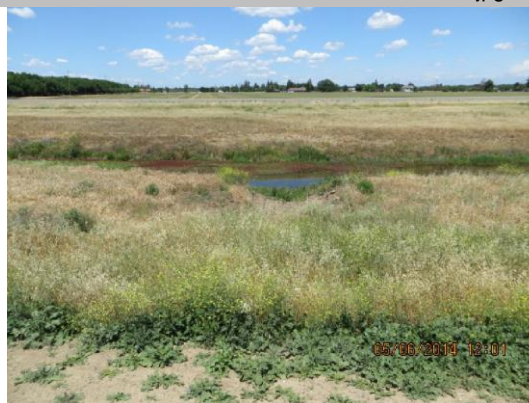
Photo 1 of 3 : UCIP_FA_2021_65149_65589.jpg

DS_ID:23388
 FS_ID:65149
 EP_NO: N/A
 Repair Type: Non-Urgent
 EVAL Issue: Unauthorized Encroachment, installed decades prior
 Crossing Status: Found
 UCIP Comments: 03/03/2021 Record was updated from No Action Needed to Non-Urgent. DMP internal video inspection has not found pipe integrity issues. LOF of crossing is less or equal to 4.0. Recommend next video inspection in 5 years. No permit was found authorizing this encroachment. CVFPB will need to review crossing to determine owner. Burrow holes observed above headwall on LS slope. Pipe is rusty and CM of pipe seems to be slightly separating at LS toe. The UCIP inspection was completed with LMA representative, H. Latu. (N. Cholewinski - GEI)
 FIELD_STRUCT_DESC: 30-inch corrugated metal drainage pipe through the levee, 9 feet below the crown. Concrete U-shaped headwall on both ends. Grouted inlet and outlet. Flap gate on the waterside (WS) end. [Additional Reference(s): DWR Levee Log, 1992. USACE San Joaquin O&M Manual 611.1, Volume F, (HLM 12.58)].

Grouted spillway on WS berm.

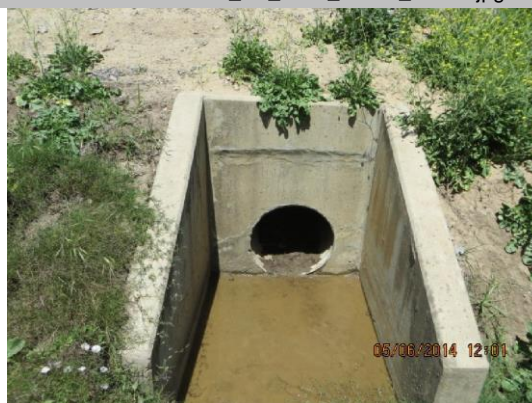
Photo 3 of 3 : UCIP_FA_2021_65149_65587.jpg

Concrete headwall on LS toe.

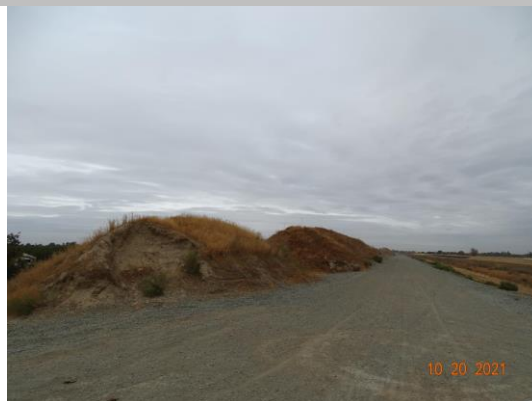
Photo 1 of 1 : FA_2021_NA0017_160_277_20211020_00687.jpg

LM Start	13.56	Rating **	U	Issue No.	277
LM End	14.01	Issue Type +	Ma	Location *	CR
Category	Earthen Levee			GPS Latitude/Longitude	
				Start	End
Item	Encroachments			37.961604 °	37.965214 °
				-121.206605 °	-121.213627 °
DWR ID	DWR_NA0017_16_s_2019_277				
Comment Code					
MA : Material					
Inspector Comment					
Fill material stored on landside crown.

View of fill material stored landside shoulder. Fall 2021

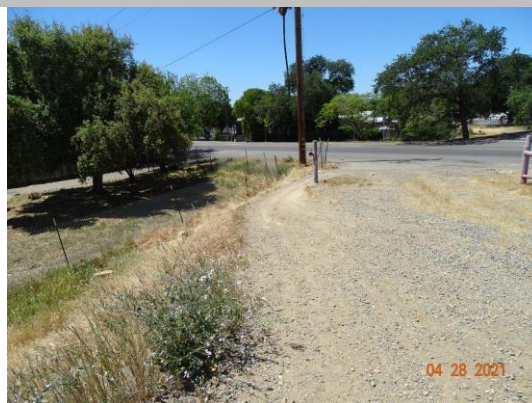
Photo 1 of 1 : FA_2021_NA0017_160_270_20210913_00120.jpg

LM Start	16.84	Rating **	M	Issue No.	270
LM End	16.84	Issue Type +	Ma	Location *	LS
Category	Earthen Levee			GPS Latitude/Longitude	
				Start	End
Item	Slope Stability			37.985132 °	37.985132 °
				-121.258825 °	-121.258825 °
DWR ID	DWR_NA0017_16_s_2021_270				
Comment Code					
S2 : Repair the levee slope damaged by foot traffic and prevent access where possible.					
Inspector Comment

View of pedestrian pathway along the landside slope. Spring 2021

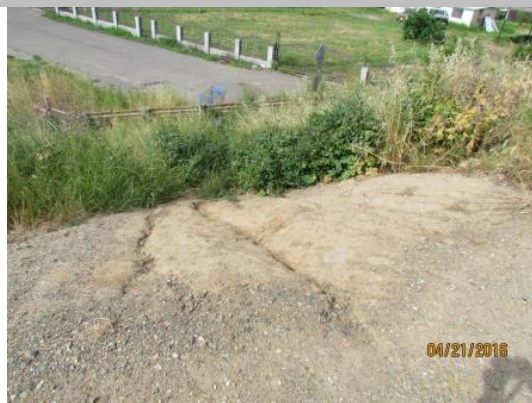
Photo 1 of 1 : FA_2021_NA0017_160_293_20210913_00131.jpg

LM Start	17.14	Rating **	M	Issue No.	293
LM End	17.14	Issue Type +	Ma	Location *	LS
Category	Earthen Levee			GPS Latitude/Longitude	
				Start	End
Item	Slope Stability			37.987210 °	37.987210 °
				-121.263501 °	-121.263501 °
DWR ID	DWR_NA0017_16_s_2016_293				
Comment Code					
S2 : Repair the levee slope damaged by foot traffic and prevent access where possible.					
Inspector Comment					
Landside slope erosion caused by foot traffic.

View of an erosion on the landside slope of the levee.

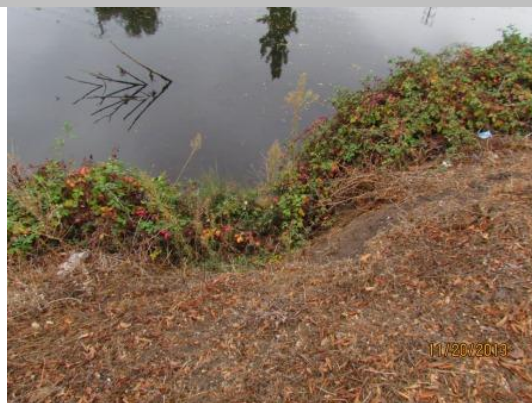
Photo 1 of 1 : FA_2021_NA0017_160_62_20210913_00087.jpg

LM Start	21.94	Rating **	A/W	Issue No.	62
LM End	21.94	Issue Type +	Ma	Location *	WS
Category	Earthen Levee			GPS Latitude/Longitude	
				Start	End
Item	Erosion / Bank Caving			37.979251 °	37.979251 °
				-121.340012 °	-121.340012 °
DWR ID	DWR_NA0017_16_f_2020_62				
Comment Code					
E1 : Note and monitor erosion site.					
Inspector Comment

Erosion was found on the waterside slope of the levee looking upstream.

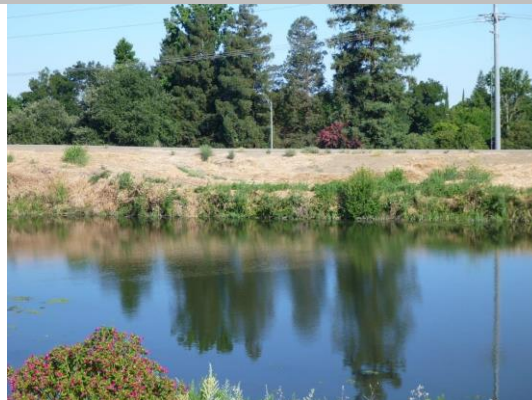
Photo 1 of 1 : LEVAL_FA_2021_474_2234.jpg

LM Start	22.19	Rating **	A/W	Issue No.	244
LM End	22.19	Issue Type +	Ma	Location *	WS
Category	Earthen Levee			GPS Latitude/Longitude	
				Start	End
Item	Erosion / Bank Caving			37.977185 °	37.977185 °
				-121.343687 °	-121.343687 °
DWR ID	LMA-301				
Comment Code					
E1 : Note and monitor erosion site.					
Inspector Comment					
2017 strom damage site, ID No. 474, LMA-301. Erosion along the left bank of the waterside slope.

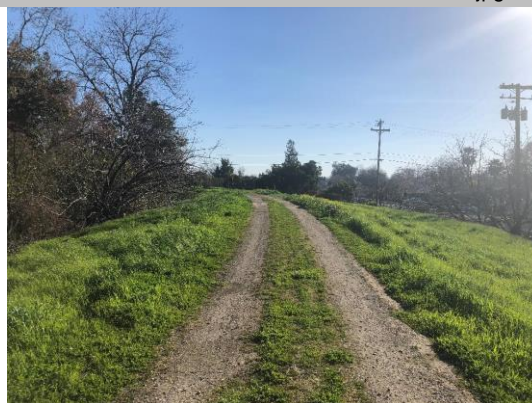
Photo 1 of 3 : UCIP_FA_2021_63483_93577.jpg

Comment Code						
Inspector Comment						
DS_ID:23409 FS_ID:63483 EP_NO: N/A Repair Type: Non-Urgent EVAL Issue: Unauthorized Encroachment, installed decades prior Crossing Status: Found UCIP Comments: 03/01/2021 Record was updated from No Action Needed to Non-Urgent. No permit was found authorizing this encroachment. CVFPB will need to review crossing to determine owner. No issues observed during inspection. The UCIP inspection was completed with LMA representative, H. Latu. (N. Cholewinski - GEI) FIELD_STRUCT_DESC: 1 of 2: 18-inch steel drainage pipe through the levee, 4.3 feet below the crown. Siphon breaker on the waterside (WS) slope. Pump house near the landside (LS) toe. (Reclamation District No. 1618). [Additional Reference(s): DWR Levee Log, 1992. USACE San Joaquin O&M Manual 611.1, Volume F, (HLM 23.36)]. FS Date: 3/1/2021

Crown Overview

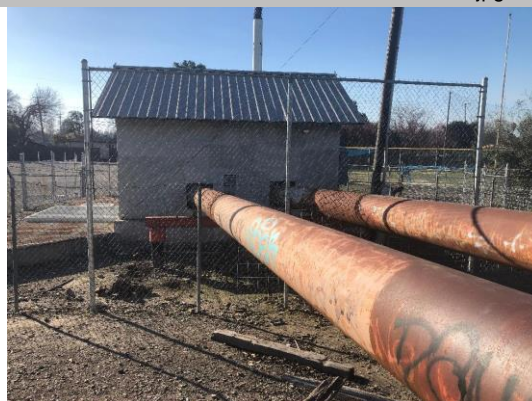
Photo 2 of 3 : UCIP_FA_2021_63483_93578.jpg

LS View: Pipe and pumphouse at LS toe.

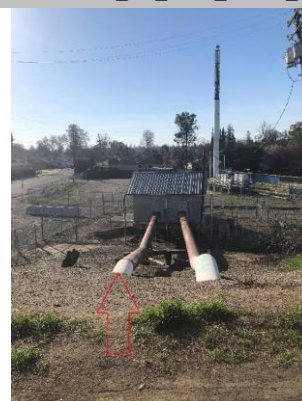
Photo 3 of 3 : UCIP_FA_2021_63483_93579.jpg

LS View: Pipe and pumphouse at LS slope and toe.

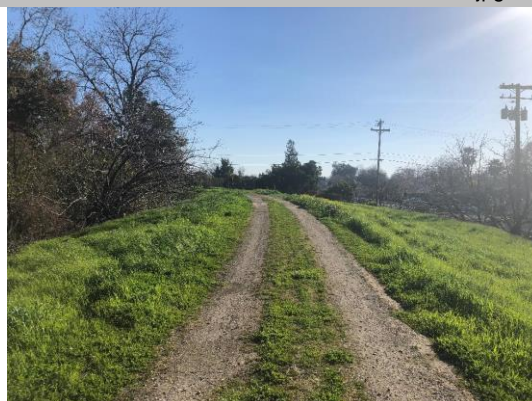
Photo 1 of 3 : UCIP_FA_2021_63482_93572.jpg

Comment Code					
Inspector Comment					
DS_ID:23503 FS_ID:63482 EP_NO: N/A Repair Type: Non-Urgent EVAL Issue: Unauthorized Encroachment, installed decades prior Crossing Status: Found UCIP Comments: 03/01/2021 Record was updated from No Action Needed to Non-Urgent. No permit was found authorizing this encroachment. CVFPB will need to review crossing to determine owner. No issues observed during inspection. The UCIP inspection was completed with LMA representative, H. Latu. (N. Cholewinski - GEI) FIELD_STRUCT_DESC: 2 of 2: 20-inch steel drainage pipe through the levee, 3 feet below the crown. Siphon breaker on the waterside (WS) slope. Pump house near the landside (LS) toe. (Reclamation District No. 1618). [Additional Reference(s): DWR Levee Log, 1992. USACE San Joaquin O&M Manual 611.1, Volume F, (HLM 23.36)]. FS Date: 3/1/2021

Crown Overview

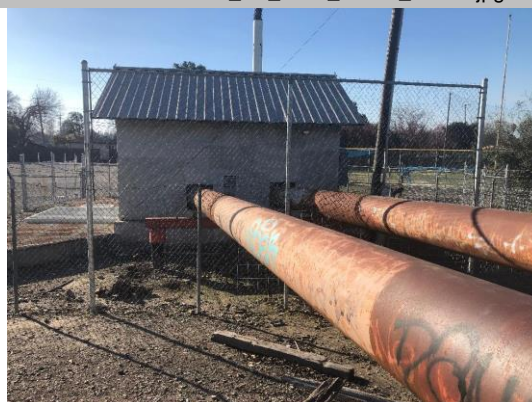
Photo 2 of 3 : UCIP_FA_2021_63482_93574.jpg

LS View: Pipe and pumphouse at LS toe.

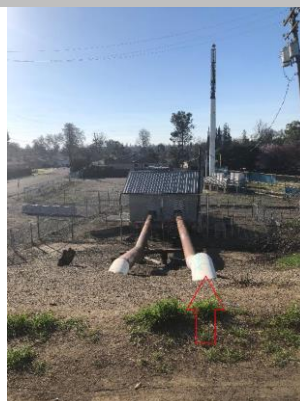
Photo 3 of 3 : UCIP_FA_2021_63482_93575.jpg

LS View: Pipe and pumphouse at LS slope and toe.

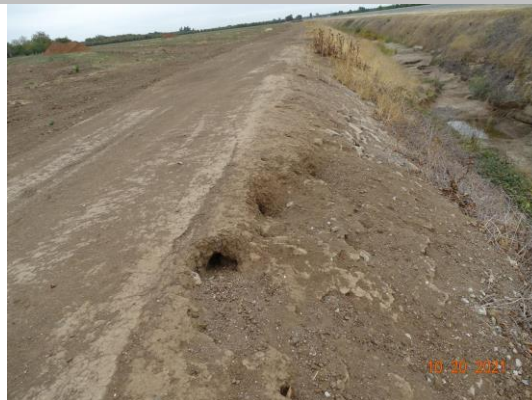
Photo 1 of 1 : FA_2021_NA0017_161_10_20211020_00018.jpg

LM Start	0.05	Rating **	U	Issue No.	10
LM End	0.06	Issue Type +	Ma	Location *	WS
Category	Earthen Levee			GPS Latitude/Longitude	
				Start	End
Item	Animal Control			37.960250 °	37.960241 °
				-121.162471 °	-121.162373 °
DWR ID	DWR_NA0017_17_f_2019_10				
Comment Code					
A3 : No rodents visible, but rodent burrows visible; need to backfill and compact or grout burrows.					
Inspector Comment

View of large animal burrows within the waterside shoulder and slope.
Fall 2021

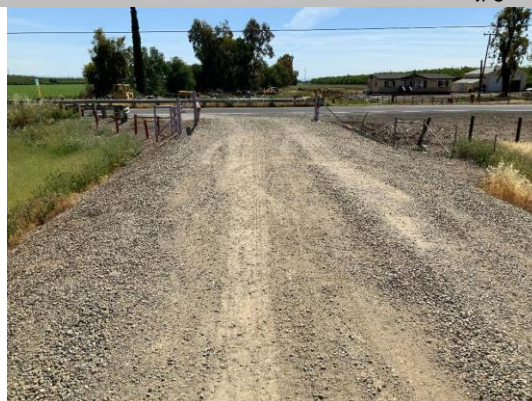
Photo 1 of 3 : UCIP_FA_2021_67115_99067.jpg

Comment Code						
Inspector Comment						
DS_ID:23952 FS_ID:67115 EP_NO: N/A Repair Type: Non-Urgent EVAL Issue: Unauthorized Encroachment, installed decades prior Crossing Status: Found UCIP Comments: 04/29/2021 The record has been upgraded from No Action Needed to Non-Urgent. No permit was found authorizing this encroachment. CVFPB will need to review crossing to determine owner. The UCIP inspection was completed with LMA representative, J. Nelson. (H. Dunn – GEI) 04/04/2014 Looks well maintained crossing. (P. Mahesh - DWR UCIP) FIELD_STRUCT_DESC: 30-inch CM pipe through the levee 6.0 feet below the crown. Concrete "U" headwalls on both ends. Flap gate on the waterward end. Grouted intake and outlet. O&M manual SJR 611.1 Vol. F- revised in 2010. FS Date: 4/29/2021

Levee crown looking upstream.

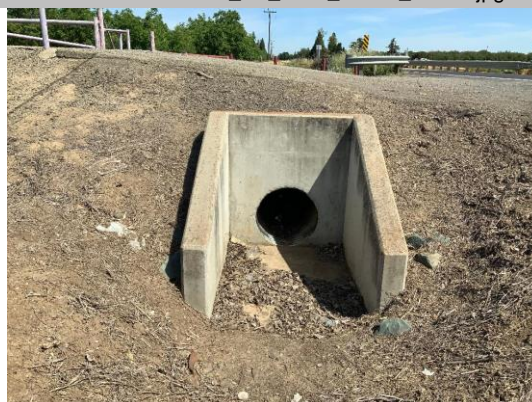
Photo 2 of 3 : UCIP_FA_2021_67115_98740.jpg

LS view: Slope and headwall at toe.

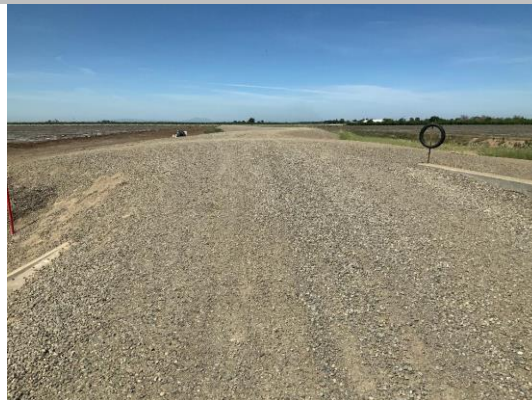
Photo 1 of 3 : UCIP_FA_2021_67111_98748.jpg

Comment Code					
Inspector Comment					
DS_ID:18541 FS_ID:67111 EP_NO: N/A Repair Type: Urgent EVAL Issue: Flood Risk Crossing Status: Found UCIP Comments: 04/29/2021 The record has been upgraded from No Action Needed to Urgent. There is a new plastic irrigation pipe going through this metal pipe that prevents the flapgate from closing. Pipe needs to be removed before flood season so flapgate can close. No permit was found authorizing this encroachment. CVFPB will need to review crossing to determine owner. The UCIP inspection was completed with LMA representative, J. Nelson. (H. Dunn – GEI) 04/04/2014 Long flood wall along the levee. (P. Mahesh - DWR UCIP) FIELD_STRUCT_DESC: 30-inch corrugated metal drainage pipe through the levee, 6 feet below the crown. Concrete U-shaped headwall on both ends. Flap gate on the waterside (WS) end. Grouted inlet and outlet. [Additional Reference(s): DWR Levee Log, 1992, 36-inch pipe listed. USACE San Joaquin O&M Manual 611.1, Volume F, (HLM 0.28)]. FS Date: 4/29/2021

Levee crown looking downstream.

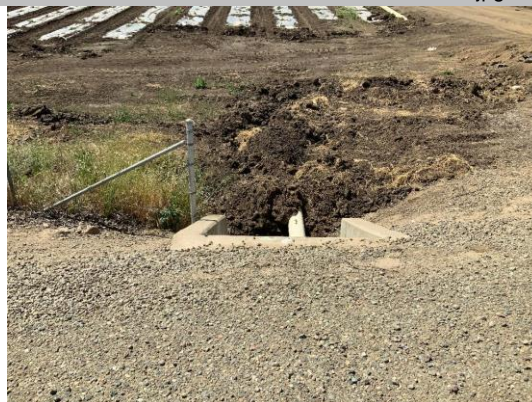
Photo 2 of 3 : UCIP_FA_2021_67111_98750.jpg

LS view: Headwall visible at toe from crown.

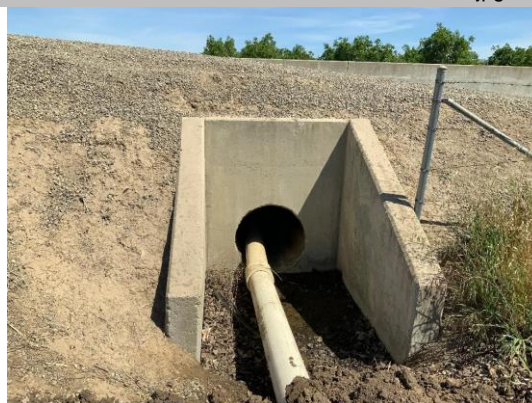
Photo 3 of 3 : UCIP_FA_2021_67111_98751.jpg

LS view: Slope and headwall at toe. Irrigation pipe going through inlet.

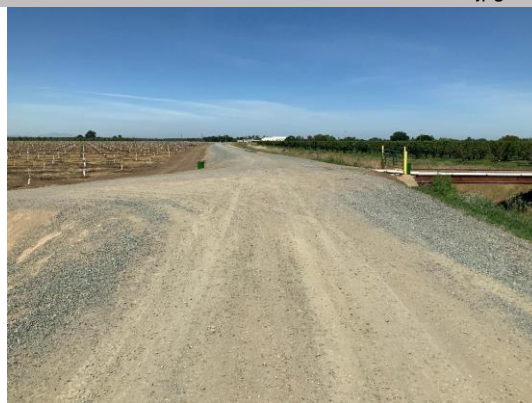
Photo 1 of 3 : UCIP_FA_2021_67112_98763.jpg

DS_ID:18539
 FS_ID:67112
 EP_NO: N/A
 Repair Type: Urgent
 EVAL Issue: Pipe Integrity
 Crossing Status: Found
 UCIP Comments: 04/29/2021 Record has been upgraded from No Action Needed to Urgent. DWR DMP internal video inspection has found pipe integrity issues. LOF of crossing is between 5 and 6. Crossing will be monitored until funding becomes available to address the issues. No permit was found authorizing this encroachment. CVFPB will need to review crossing to determine owner. The UCIP inspection was completed with LMA representative, J. Nelson. (H. Dunn – GEI)04/04/2014 May need cleaning the pipe. (P. Mahesh - DWR UCIP)
 FIELD_STRUCT_DESC: 30-inch corrugated metal drainage pipe through the levee, 6 feet below the crown. Concrete U-shaped headwalls on both ends. Flap gate on the waterside (WS) end. Grouted inlet and outlet. [Additional Reference(s): DWR Levee Log, 1992, 36-inch pipe listed. USACE San Joaquin O&M Manual 611.1, Volume F, (HLM 0.54)].

Levee crown looking downstream.

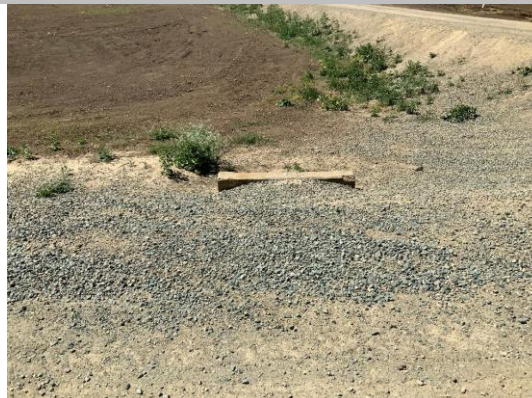
Photo 2 of 3 : UCIP_FA_2021_67112_98764.jpg

LS view: Headwall visible at toe from crown.

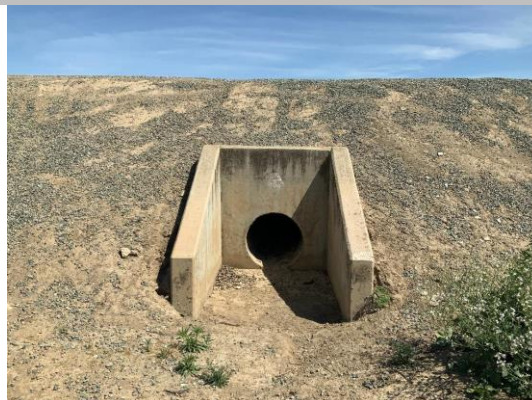
Photo 3 of 3 : UCIP_FA_2021_67112_98765.jpg

LS view: Slope and headwall at toe.
