**Flood Control Project Maintenance
Levee Inspections**

Maintenance Issue Types Only, Levee Inspection Report By Mile - Fall 2022

San Joaquin County Flood Control and Water Conservation District

Waterway	Bank	Unit Miles	Inspection Start/End	Inspector
Unit No. 01 Littlejohn Creek	Left	2.59	10/13/2022 10/13/2022	Alberto De Leon

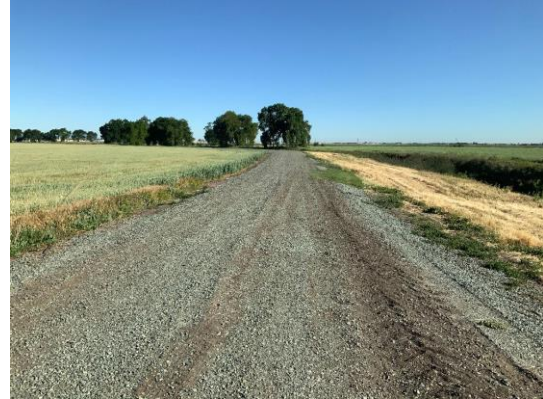
Photo 1 of 3 : UCIP_FA_2022_77392_96776.jpg

Comment Code					
Inspector Comment					
DS_ID:23992 FS_ID:77392 EP_NO: N/A Repair Type: Non-Urgent EVAL Issue: 10, Unauthorized Modification or Non-Compliant Permit Crossing Status: Found UCIP Comments: 04/27/2021 The record has been upgraded from No Action Needed to Non-Urgent. Water filtration plant and tanks no longer present on LS. Heavy vegetation covering WS pipe over bridge, recommend cleaning around pipe. Levee prism in this section appears to be less than 3 feet. No permit was found authorizing this encroachment. CVFPB will need to review crossing to determine owner. The UCIP inspection was completed with LMA representative, J. Nelson. (H. Dunn – GEI) 03/25/2014 One 4-inch pvc pipe on the waterside levee slope. It is not clear whether the pvc pipe goes through the levee. One air vent on waterside and another across the channel. Water filter plant on landside. (P. Tariq - DWR UCIP)Not found : 24-inch CMP through levee and with flap gate. On landside a vertical pump on wooden structure; walkway to the pump; service pole and switch box. Pump is connected to 8-inch steel pipe for about 100 ft. 24-inch CMP continues through the levee. FIELD_STRUCT_DESC: 8-inch steel storm drainage pipe through the levee, 2.0 feet below the crown. Pipe goes over the top of the channel on a wooden structure. One air vent on the waterside (WS) and another air vent across the channel. Water filtration plant on the landside (LS). [Additional Reference(s): DWR Levee Log, 1977, (HLM 0.44), 14-inch pipe listed]. FS Date: 4/27/2021

Levee crown looking downstream.

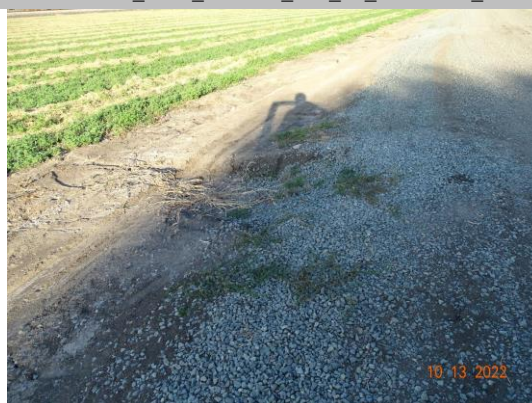
Photo 1 of 1 : FA_2022_NA0017_148_32_20221022_00058.jpg

LM Start	0.61	Rating **	M	Issue No.	32
LM End	0.61	Issue Type +	Ma	Location *	LS
Category	Earthen Levee			GPS Latitude/Longitude	
				Start	End
Item	Erosion / Vehicle Traffic			37.877320 °	37.877320 °
				-121.239831 °	-121.239831 °
DWR ID	DWR_NA0017_01_f_2022_32				
Comment Code					
E6 : Repair the levee slope damaged by vehicle traffic and prevent access where possible.					
Inspector Comment

View of erosion caused by farming equipment along the landside slope.
Fall 2022

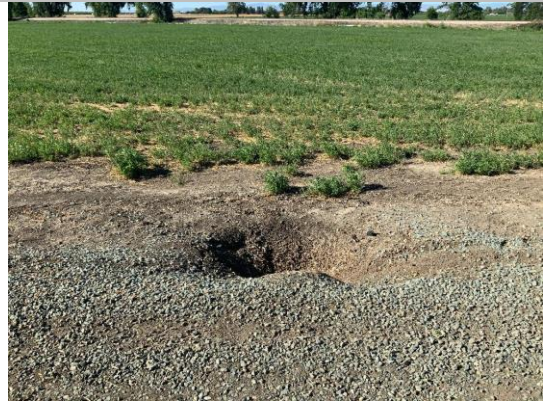
Photo 2 of 3 : UCIP_FA_2022_74230_96792.jpg

Comment Code					
Inspector Comment					
DS_ID:17973 FS_ID:74230 EP_NO: N/A Repair Type: Urgent EVAL Issue: 3a, Flood Risk Crossing Status: Found UCIP Comments: 04/27/2021 Pipe status is still Urgent. Slidegate no longer on WS, pipe is open on both ends. LS pipe edges are bent and warped. DWR DMP internal video inspection has found pipe integrity issues. LOF of crossing is between 4.1 and 5. Crossing will be monitored until funding becomes available for rehabilitation. Levee prism in this section appears to be less than 3 feet. No permit was found authorizing this encroachment. CVFPB will need to review crossing to determine owner. The UCIP inspection was completed with LMA representative, J. Nelson. (H. Dunn – GEI) 11/02/2018 Inlet deformed. Outlet missing a slide gate. The LMA states that a new slide gate will be installed in about two weeks. Inlet and outlet have dirt and vegetation issues. Crossing remains "Urgent" until a new slide gate is installed. Contact the LMA to see if they have photographic evidence that a new slide gate was put in. (A. McDonald - DWR UCIP)10/18/2018 Inlet deformed. Outlet missing a slide gate. This means that the pipe cannot be closed during high water. I have escalated this crossing from "No Action Needed" to "Urgent" due to the straight through pipe which could cause flooding during high water. There is a hole in the inlet, due to the deformity. It was most likely ran over by heavy equipment. I do not see enough evidence for an internal pipe inspection. (A. McDonald - DWR UCIP)03/25/2014 May need cleaning of mud in inlet pipe. (W. Wylie - DWR UCIP) FIELD_STRUCT_DESC: 24-inch corrugated metal drainage culvert (CMP) through the levee, 4.2 feet below the crown. Slide gate on the waterside (WS) end. [Additional Reference(s): DWR Levee Log, 1977, (HLM 1.00). USACE San Joaquin O&M Manual, Unit No. 613, Part C, May 1963, Revised 15 April 2010, (Station 98+65). USACE As-Built File No. CA-2-6-147, Sheet No. 147/22, 25 March 1954, (Station 98+65)]. FS Date: 4/27/2021

LS view: Slope from crown, inlet visible at toe.

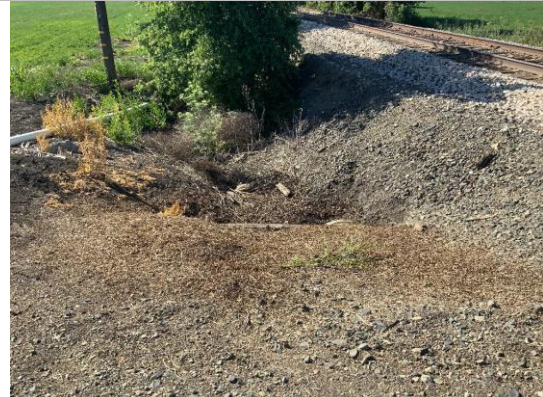
Photo 2 of 3 : UCIP_FA_2022_74232_96808.jpg

Comment Code					
Inspector Comment					
DS_ID:17972 FS_ID:74232 EP_NO: N/A Repair Type: Non-Urgent EVAL Issue: 11, Maintenance Compliance Issue Crossing Status: Found UCIP Comments: 04/27/2021 The record has been upgraded from No Action Needed to Non-Urgent. Some vegetation in front of WS flapgate, recommend removal. DWR DMP internal video inspection has not found pipe integrity issues. LOF of crossing is less or equal to 4.0. Recommend next video inspection in 5 years. Levee prism in this section appears to be less than 3 feet. No permit was found authorizing this encroachment. CVFPB will need to review crossing to determine owner. The UCIP inspection was completed with LMA representative, J. Nelson. (H. Dunn – GEI) 11/02/2018 Inlet and outlet cleared of dirt by the LMA. Crossing has been downgraded to "No Action Needed." (A. McDonald - DWR UCIP)03/25/2014 LS vegetation debris and mud on the inlet ditch and inside the pipe. (P. Amatya - DWR UCIP) FIELD_STRUCT_DESC: 1 of 2: 36-inch corrugated metal drainage pipe (CMP) through the levee, 6.6 feet below the crown. Flap gate on the waterside (WS) end. [Additional Reference(s): DWR Levee Log, 1977, (HLM 1.05). USACE San Joaquin O&M Manual, Unit No. 613, Part C, May 1963, Revised 15 April 2010, (Station 94+40). USACE As-Built File No. CA-2-6-147, Sheet No. 147/22, 25 March 1954, (Station 94+40)]. FS Date: 4/27/2021

LS view: Headwall visible at toe from crown.

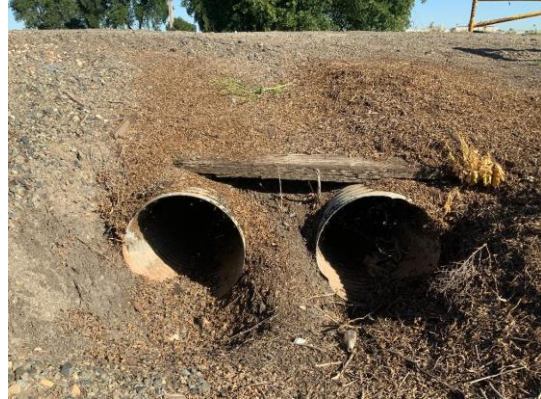
Photo 3 of 3 : UCIP_FA_2022_74232_96809.jpg

LS view: Headwall and pipe inlets at toe.

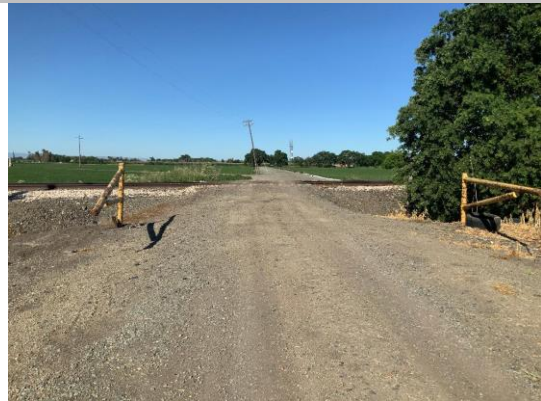
Photo 1 of 3 : UCIP_FA_2022_74233_96814.jpg

Levee crown looking downstream.

Comment Code					
Inspector Comment					
DS_ID:23995 FS_ID:74233 EP_NO: N/A Repair Type: Non-Urgent EVAL Issue: 5, Pipe Damage Crossing Status: Found UCIP Comments: 04/27/2021 The record has been upgraded from No Action Needed to Non-Urgent. DWR DMP internal video inspection has found pipe integrity issues. LOF of crossing is between 4.1 and 5. Crossing will be monitored until funding becomes available for rehabilitation. Vegetation covering WS flapgates, recommend removal. The levee prism in this section appears to be less than 3 feet. No permit was found authorizing this encroachment. CVFPB will need to review crossing to determine owner. The UCIP inspection was completed with LMA representative, J. Nelson. (H. Dunn – GE11/02/2018 Inlet and outlet covered in dirt. Inlet and outlet cleared of dirt by the LMA. (A. McDonald - DWR UCIP)03/25/2014 Needs cleaning and clearing of the culvert. (P. Amatya - DWR UCIP) FIELD_STRUCT_DESC: 2 of 2: 36-inch corrugated metal drainage pipe (CMP) through the levee, 6.6 feet below the crown. Flap gate on the waterside (WS) end. [Additional Reference(s): DWR Levee Log, 1977, (HLM 1.05). USACE San Joaquin O&M Manual, Unit No. 613, Part C, May 1963, Revised 15 April 2010, (Station 94+40). USACE As-Built File No. CA-2-6-147, Sheet No. 147/22, 25 March 1954, (Station 94+40)]. FS Date: 4/27/2021

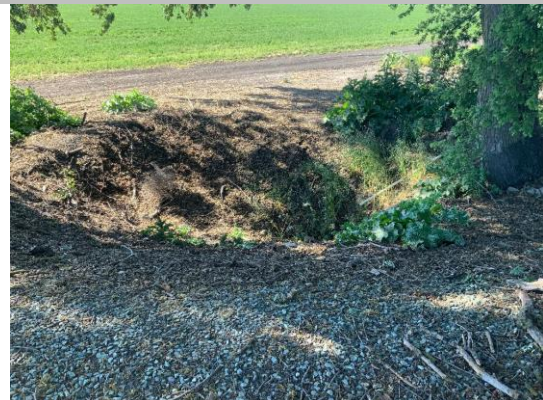
Photo 2 of 3 : UCIP_FA_2022_74235_96823.jpg

Comment Code						
Inspector Comment						
DS_ID:23985 FS_ID:74235 EP_NO: N/A Repair Type: Urgent EVAL Issue: 1, Pipe Integrity Crossing Status: Found UCIP Comments: 04/27/2021 Record updated from No Action Needed to Urgent. DMP internal video inspection has found pipe integrity issues. LOF of crossing is between 5 and 6. Crossing will be monitored until funding becomes available to address the issues. LS and WS pipe end and flapgate both partially covered by vegetation debris, recommend removal. The levee prism in this section appears to be less than 3 feet. No permit was found authorizing this encroachment. CVFPB will need to review crossing to determine owner. The UCIP inspection was completed with LMA representative, J. Nelson. (H. Dunn – GEI) 11/02/2018 Inlet and outlet cleared of dirt and vegetation by the LMA. Crossing has been downgraded to "No Action Needed." (A. McDonald - DWR UCIP)03/25/2014 Debris and mud on inlet ditch and inside pipe. Needs cleaning and clearing the culvert. (P. Amatya - DWR UCIP) FIELD_STRUCT_DESC: 30-inch corrugated metal drainage pipe (CMP) through the levee, 11.0 feet below the crown. Flap gate on the waterside (WS) end. [Additional Reference(s): USACE San Joaquin O&M Manual, Unit No. 613, Part C, May 1963, Revised 15 April 2010, (Station 83+00). USACE As-Built File No. CA-2-6-147, Sheet No. 147/1, 25 March 1954, (Station 83+00)]. FS Date: 4/27/2021

LS view: Toe from crown.

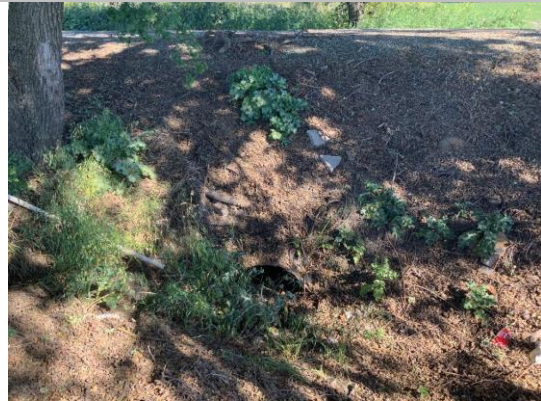
Photo 3 of 3 : UCIP_FA_2022_74235_96824.jpg

LS view: Pipe inlet at toe.

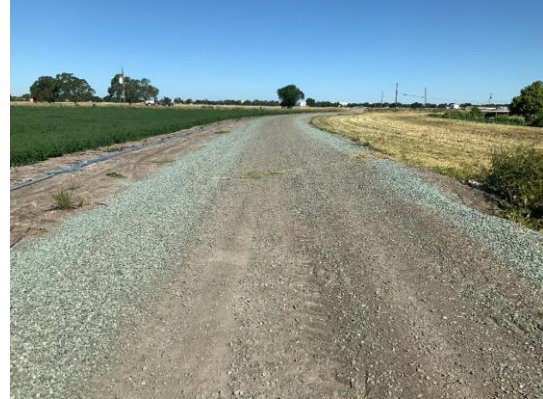
Photo 1 of 3 : UCIP_FA_2022_74236_96829.jpg

Comment Code						
Inspector Comment						
DS_ID:17970 FS_ID:74236 EP_NO: N/A Repair Type: Urgent EVAL Issue: 1, Pipe Integrity Crossing Status: Found UCIP Comments: 04/27/2021 The record has been upgraded from Non-Urgent to Urgent. DWR DMP internal video inspection has found pipe integrity issues. LOF of crossing is between 5 and 6. Crossing will be monitored until funding becomes available to address the issues. The levee prism in this section appears to be less than 3 feet. No permit was found authorizing this encroachment. CVFPB will need to review crossing to determine owner. The UCIP inspection was completed with LMA representative, J. Nelson. (H. Dunn – GEI)11/02/2018 Inlet still deformed. Inlet and outlet cleared of dirt and vegetation by the LMA. Crossing continues to be rated "Non-Urgent." (A. McDonald - DWR UCIP)03/25/2014 Needs cleaning and clearing the culvert. (P. Amatya - DWR UCIP) FIELD_STRUCT_DESC: 24-inch corrugated metal drainage pipe (CMP) through the levee, 4.1 feet below the crown. Flap gate on the waterside (WS) end. [Additional Reference(s): DWR Levee Log, 1977, (HLM 1.44). USACE San Joaquin O&M Manual, Unit No. 613, Part C, May 1963, Revised 15 April 2010, (Station 76+60). USACE As-Built File No. CA-2-6-147, Sheet No. 147/1, 25 March 1954, (Station 76+60)]. FS Date: 4/27/2021

Levee crown looking downstream.

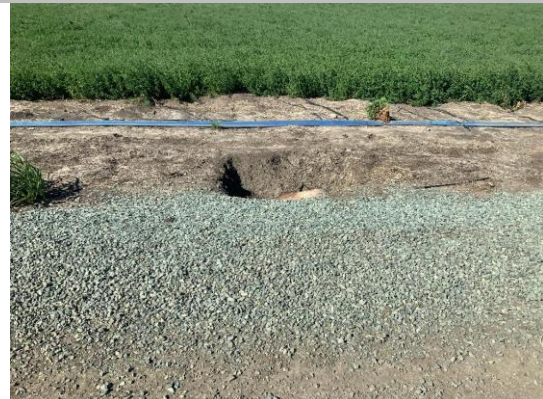
Photo 2 of 3 : UCIP_FA_2022_74236_96830.jpg

LS view: Toe from crown.

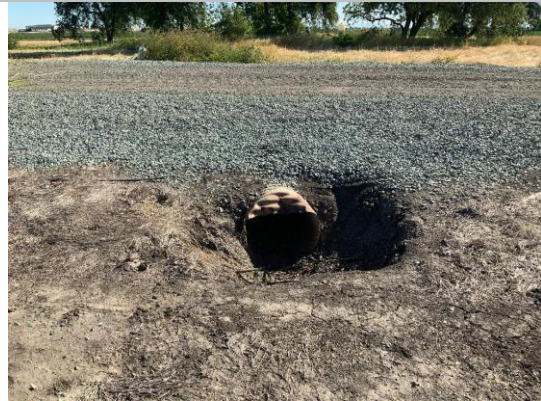
Photo 3 of 3 : UCIP_FA_2022_74236_96831.jpg

LS view: Pipe inlet at toe.

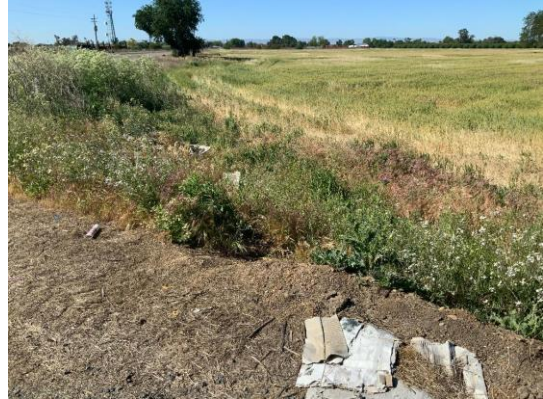
Photo 2 of 3 : UCIP_FA_2022_74238_96842.jpg

DS_ID:17969
FS_ID:74238
EP_NO: N/A
Repair Type: Non-Urgent
EVAL Issue: 10, Unauthorized Modification or Non-Compliant Permit Crossing Status: Found
UCIP Comments: 04/27/2021 Pipe status is still Non-Urgent. This pipe appears abandoned, no standpipe on WS and no inlet structure on LS. Only pipe with appurtenance left on WS. The levee prism in this section appears to be less than 3 feet. No permit was found authorizing this encroachment. CVFPB will need to review crossing to determine owner. The UCIP inspection was completed with LMA representative, J. Nelson. (H. Dunn – GEI) 03/25/2014 Appears abandoned and should be verified as having been done so properly. (P. Tariq - DWR UCIP) Concrete standpipe on waterside. Abandoned gate valve on waterside. Steel pipe disconnected with the standpipe. Inlet structure with steel gates and 18-inch alfalfa valve on landside.
FIELD_STRUCT_DESC: 18-inch reinforced concrete drainage pipe (RCP) through the levee, 6.2 feet below the crown. [Additional Reference(s): DWR Levee Log, 1977, (HLM 1.60). USACE San Joaquin O&M Manual, Unit No. 613, Part C, May 1963, Revised 15 April 2010, (Station 68+90). USACE As-Built File No. CA-2-6-147, Sheet No. 147/1, 25 March 1954, (Station 68+90), 21-inch pipe listed].

LS view: Slope from crown, no inlet structure seen.

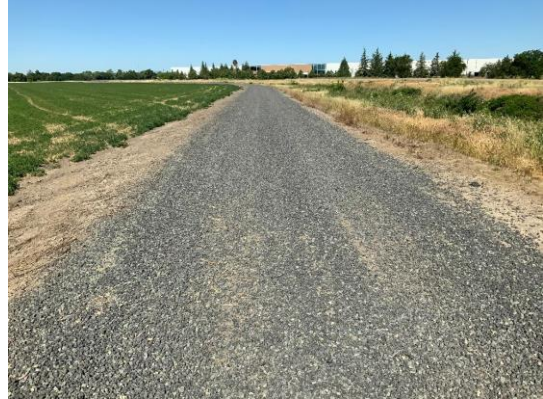
Photo 1 of 3 : UCIP_FA_2022_74320_96854.jpg

Comment Code					
Inspector Comment					
DS_ID:17968 FS_ID:74320 EP_NO: N/A Repair Type: Non-Urgent EVAL Issue: Crossing Status: Not Found UCIP Comments: 04/27/2021 The record has been upgraded from No Action Needed to Non-Urgent. Pipe not found by visual inspection. No permit was found authorizing this encroachment. CVFPB will need to review crossing to determine owner. The UCIP inspection was completed with LMA representative, J. Nelson. (H. Dunn – GEI) FIELD_STRUCT_DESC: 24-inch corrugated metal drainage pipe (CMP) through the levee, 5.3 feet below the crown. Flap gate on the waterside (WS) end. [Additional Reference(s): DWR Levee Log, 1977, (HLM 1.96). USACE San Joaquin O&M Manual, Unit No. 613, Part C, May 1963, Revised 15 April 2010, (Station 50+00). USACE As-Built File No. CA-2-6-147, Sheet No. 147/1, 25 March 1954, (Station 50+00)]. FS Date: 4/27/2021

Levee crown looking downstream.

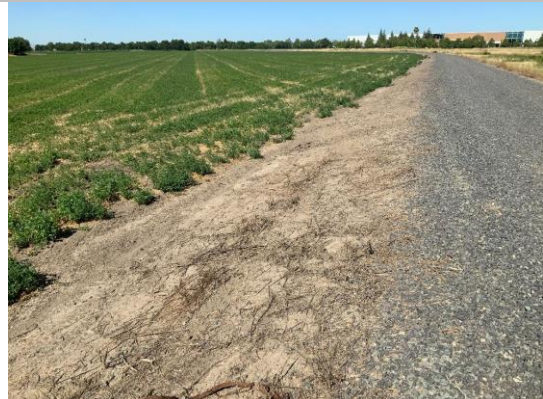
Photo 2 of 3 : UCIP_FA_2022_74320_96855.jpg

LS view: Slope from crown, no pipe visible.

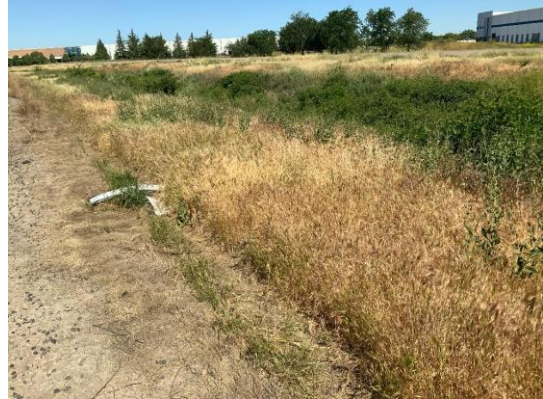
Photo 3 of 3 : UCIP_FA_2022_74320_96856.jpg

WS view: Slope from crown, no pipe visible.

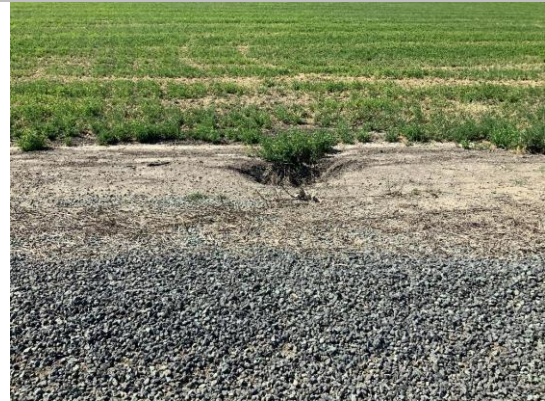
Photo 2 of 3 : UCIP_FA_2022_74325_96872.jpg

Comment Code					
Inspector Comment					
DS_ID:17966 FS_ID:74325 EP_NO: N/A Repair Type: Non-Urgent EVAL Issue: 11, Maintenance Compliance Issue Crossing Status: Found UCIP Comments: 04/27/2021 The record has been upgraded from No Action Needed to Non-Urgent. WS flapgate completely covered in vegetation and LS inlet has some sediment buildup inside, recommend cleaning on both ends. DWR DMP internal video inspection has not found pipe integrity issues. LOF of crossing is less or equal to 4.0. Recommend next video inspection in 5 years No permit was found authorizing this encroachment. CVFPB will need to review crossing to determine owner. The levee prism in this section appears to be less than 3 feet. The UCIP inspection was completed with LMA representative, J. Nelson. (H. Dunn – GEI) 11/02/2018 Inlet uncovered from the dirt by the LMA. Some vegetation at the flap gate. Crossing continues to be rated "No Action Needed." (A. McDonald - DWR UCIP)03/25/2014 Grouted riprap outlet box and concrete outfall pipe on waterside. Pipe not visible on landside. (P. Amatya - DWR UCIP) FIELD_STRUCT_DESC: 24-inch corrugated metal drainage pipe (CMP) through the levee, 5.0 feet below the crown. Flap gate on the waterside (WS) end. Grouted riprap outlet box and concrete outfall pipe on the WS. [Additional Reference(s): DWR Levee Log, 1977, (HLM 2.82). USACE San Joaquin O&M Manual, Unit No. 613, Part C, May 1963, Revised 15 April 2010, (Station 4+00). USACE As-Built File No. CA-2-6-147, Sheet No. 147/1, 25 March 1954, (Station 4+00)]. FS Date: 4/27/2021

LS view: Slope from crown.

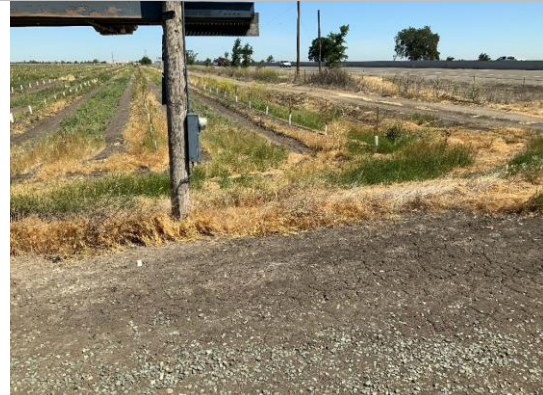
Photo 2 of 3 : UCIP_FA_2022_74364_96980.jpg

Comment Code						
Inspector Comment						
DS_ID:23987 FS_ID:74364 EP_NO: N/A Repair Type: Non-Urgent EVAL Issue: Crossing Status: Not Found UCIP Comments: 04/28/2021 Pipe status is still Non-Urgent. Pipe not found in the field. No permit was found authorizing this encroachment. CVFPB will need to review crossing to determine owner. The UCIP inspection was completed with LMA representative, J. Nelson. (H. Dunn – GEI) 04/02/2014 Not found: 24-inch CM pipe with flap gate on waterside of the levee. O&M Manual May 1963 (SJR 613C Vol 15). Probably, the pipe mentioned in desk study is one across the channel on other bank of the creek. Needs confirmation from DWR inspector or LMA. (P. Amatya - DWR) FIELD_STRUCT_DESC: 24-inch corrugated metal gravity drainage pipe (CMP) through the levee, invert elevation 25.0 feet. Flap gate on the waterside (WS) end. [Additional Reference(s): USACE San Joaquin O&M Manual, Unit No. 613, Part C, May 1963, Revised 15 April 2010, (Station 176+80 "N"). USACE As-Built File No. CA-2-6-147, Sheet No. 147/2, 25 March 1954, (Station 176+80 "N")]. FS Date: 4/28/2021

LS view: Slope from crown, no pipe visible.

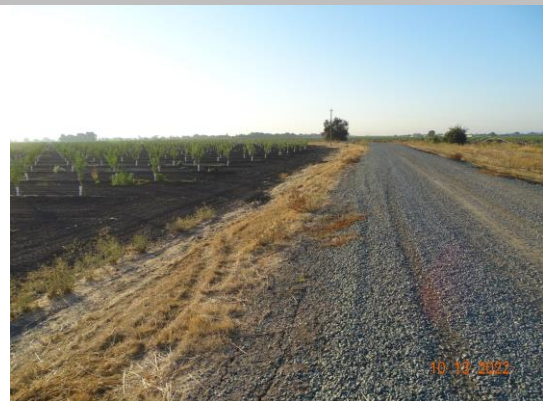
Photo 1 of 1 : FA_2022_NA0017_149_32_20221022_00089.jpg

LM Start	0.01	Rating **	A	Issue No.	32
LM End	1.46	Issue Type +	Ma	Location *	LS
Category	Earthen Levee			GPS Latitude/Longitude	
				Start	End
Item	Vegetation			37.875116 °	37.879639 °
				-121.220099 °	-121.243313 °
DWR ID	DWR_NA0017_02_f_2022_32				
Comment Code					
V1 : Control annual grass and weeds on the levee slopes and easements.					
Inspector Comment					
The annual vegetation is well maintained.

View of well maintained vegetation on the landside slope and easement.
Fall 2022

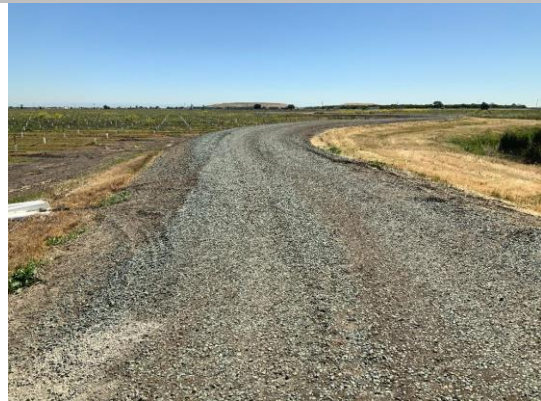
Photo 1 of 3 : UCIP_FA_2022_74365_96992.jpg

Comment Code						
Inspector Comment						
DS_ID:17986 FS_ID:74365 EP_NO: N/A Repair Type: Urgent EVAL Issue: 3a, Flood Risk Crossing Status: Found UCIP Comments: 04/28/2021 The record has been upgraded from No Action Needed to Urgent. No flapgate on the WS, pipe is open on both ends. There is an 8inch plastic pipe now going through this metal pipe that looks to go underground possibly under the channel on WS. Need more information from owner. No permit was found authorizing this encroachment. CVFPB will need to review crossing to determine owner. The UCIP inspection was completed with LMA representative, J. Nelson. (H. Dunn – GEI) 11/02/2018 Inlet cleared of dirt and vegetation by the LMA. Crossing continues to be rated "No Action Needed." (A. McDonald - DWR UCIP)04/02/2014 May need cleaning. (P. Amatya - DWR UCIP) FIELD_STRUCT_DESC: 24-inch corrugated metal gravity drainage pipe (CMP) through the levee, 5.0 feet below the crown. Flap gate on the waterside (WS) end. [Additional Reference(s): DWR Levee Log, 1977, (HLM 0.50). USACE San Joaquin O&M Manual, Unit No. 613, Part C, May 1963, Revised 15 April 2010, (Station 148+18 "N"). USACE As-Built File No. CA-2-6-147, Sheet No. 147/2, 25 March 1954, (Station 148+18 "N")]. FS Date: 4/28/2021

Levee crown looking upstream.

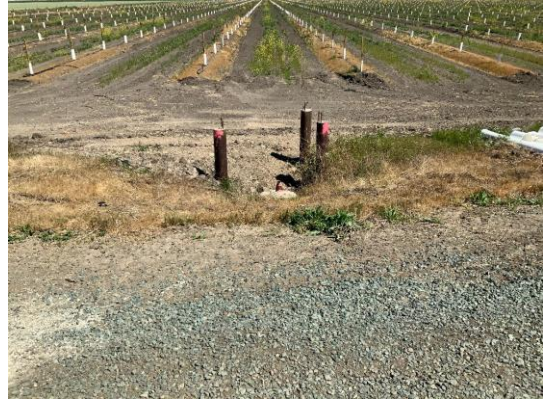
Photo 2 of 3 : UCIP_FA_2022_74365_96994.jpg

LM Start	0.50	Rating **	U	Issue No.	38 (cont)
LM End	0.50	Issue Type +	Ma	Location *	
Category	Supplemental			GPS Latitude/Longitude	
				Start	End
Item	DWR UCIP LMA Responsibility			37.875178 °	37.875178 °
				-121.228514 °	-121.228514 °
DWR ID	17986

LS view: Pipe end visible at toe from crown.

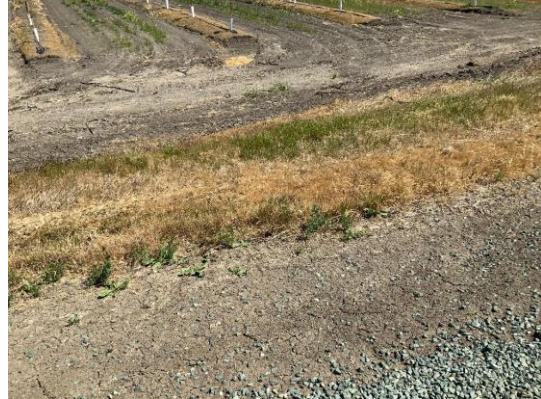
Photo 1 of 3 : UCIP_FA_2022_74366_96997.jpg

Comment Code						
Inspector Comment						
DS_ID:23986 FS_ID:74366 EP_NO: N/A Repair Type: Non-Urgent EVAL Issue: Crossing Status: Not Found UCIP Comments: 04/28/2021 The record has been upgraded from No Action Needed to Non-Urgent. Pipe not found by visual inspection. No permit was found authorizing this encroachment. CVFPB will need to review crossing to determine owner. The UCIP inspection was completed with LMA representative, J. Nelson. (H. Dunn – GEI) FIELD_STRUCT_DESC: 10-inch steel drainage discharge pipe through the levee, 2.0 feet below the crown. Gate valve on the waterside (WS). Pump structure on the landside (LS). [Additional Reference(s): USACE San Joaquin O&M Manual, Unit No. 613, Part C, May 1963, Revised 15 April 2010, (Station 148+18 "N"). USACE As-Built File No. CA-2-6-147, Sheet No. 147/2, 25 March 1954, (Station 148+18 "N")]. FS Date: 4/28/2021

LS view: Slope and toe from crown, no pipe visible.

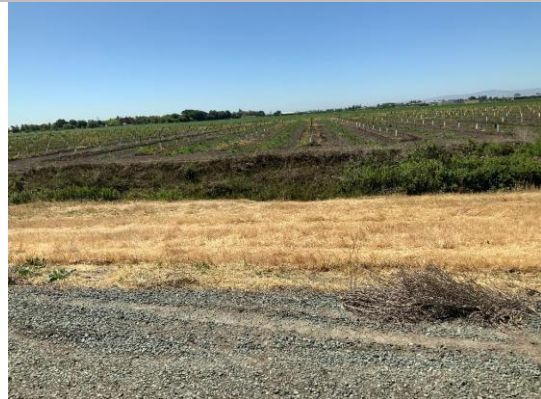
Photo 2 of 3 : UCIP_FA_2022_74366_96998.jpg

WS view: Slope from crown, no pipe visible.

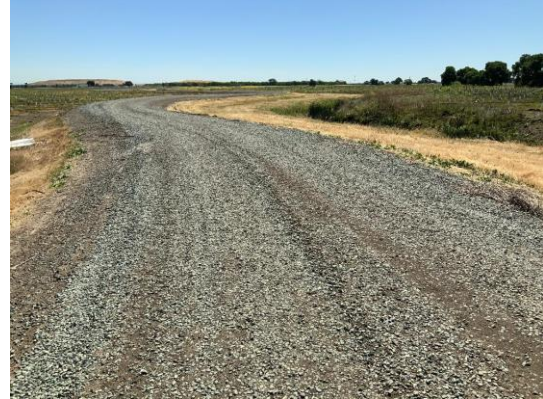
Photo 3 of 3 : UCIP_FA_2022_74366_96999.jpg

Levee crown looking upstream.

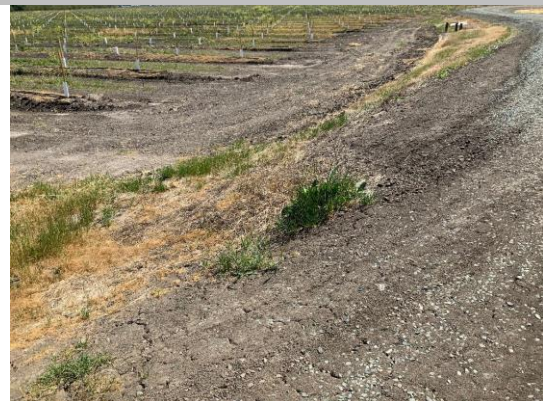
Photo 1 of 3 : UCIP_FA_2022_74368_97000.jpg

DS_ID:23982
 FS_ID:74368
 EP_NO: N/A
 Repair Type: Non-Urgent
 EVAL Issue:
 Crossing Status: Not Found
 UCIP Comments: 04/28/2021 The record has been upgraded from No Action Needed to Non-Urgent. Pipe not found by visual inspection. No permit was found authorizing this encroachment. CVFPB will need to review crossing to determine owner. The UCIP inspection was completed with LMA representative, J. Nelson. (H. Dunn – GEI)
 FIELD_STRUCT_DESC: 24-inch corrugated metal gravity drainage pipe (CMP) through the levee, invert elevation 24.0 feet. Flap gate on the waterside (WS) end. [Additional Reference(s): USACE San Joaquin O&M Manual, Unit No. 613, Part C, May 1963, Revised 15 April 2010, (Station 146+40 "N"). USACE As-Built File No. CA-2-6-147, Sheet No. 147/2, 25 March 1954, (Station 146+40 "N")].
 FS Date: 4/28/2021

LS view: Slope from crown, no pipe visible.

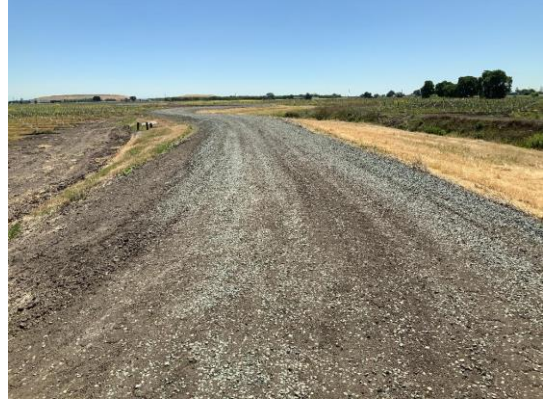
Photo 2 of 3 : UCIP_FA_2022_74368_97001.jpg

Levee crown looking upstream.

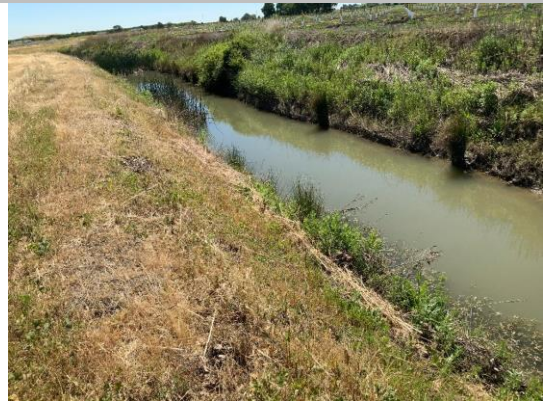
Photo 3 of 3 : UCIP_FA_2022_74368_97002.jpg

WS view: Slope from berm, no pipe visible.

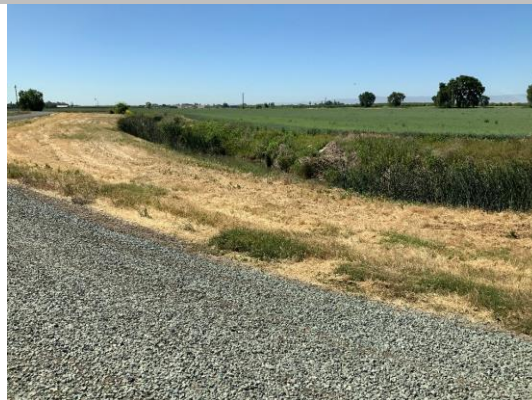
Photo 3 of 3 : UCIP_FA_2022_77394_97008.jpg

WS view: Slope from crown, no pipe visible.

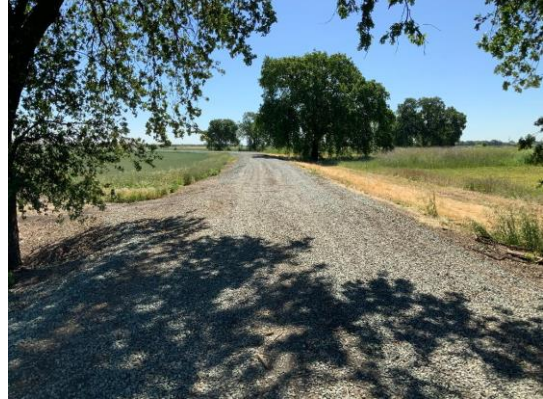
Photo 1 of 3 : UCIP_FA_2022_74371_97012.jpg

Comment Code					
Inspector Comment					
DS_ID:17983 FS_ID:74371 EP_NO: N/A Repair Type: Non-Urgent EVAL Issue: Crossing Status: Found UCIP Comments: 04/28/2021 The record has been upgraded from No Action Needed to Non-Urgent. No permit was found authorizing this encroachment. CVFPB will need to review crossing to determine owner. The UCIP inspection was completed with LMA representative, J. Nelson. (H. Dunn – GEI) 11/02/2018 Inlet and outlet cleared of dirt and vegetation by the LMA. Crossing has been downgraded to "No Action Needed." (A. McDonald - DWR UCIP)04/02/2014 Needs cleaning and clearing the culvert. (P. Amatya - DWR UCIP) FIELD_STRUCT_DESC: 24-inch corrugated metal gravity drainage pipe (CMP) through the levee, 6.4 feet below the crown. Flap gate on the waterside (WS) end. [Additional Reference(s): DWR Levee Log, 1977, (HLM 1.08). USACE San Joaquin O&M Manual, Unit No. 613, Part C, May 1963, Revised 15 April 2010, (Station 114+50). USACE As-Built File No. CA-2-6-147, Sheet No. 147/2, 25 March 1954, (Station 114+50)]. FS Date: 4/28/2021

Levee crown looking upstream.

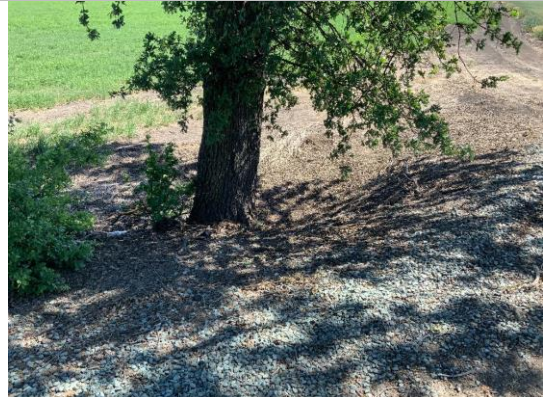
Photo 2 of 3 : UCIP_FA_2022_74371_97013.jpg

LS view: Slope and toe from crown.

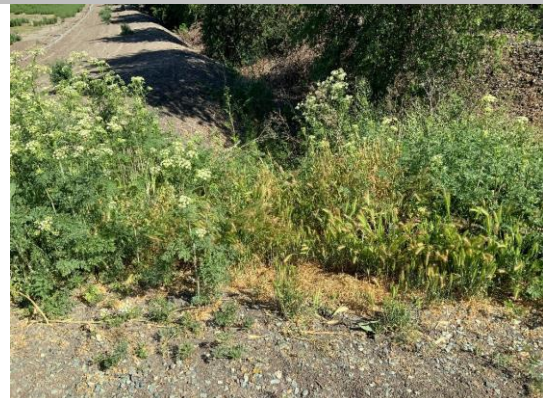
Photo 2 of 3 : UCIP_FA_2022_74381_97066.jpg

LS view: Toe from crown.

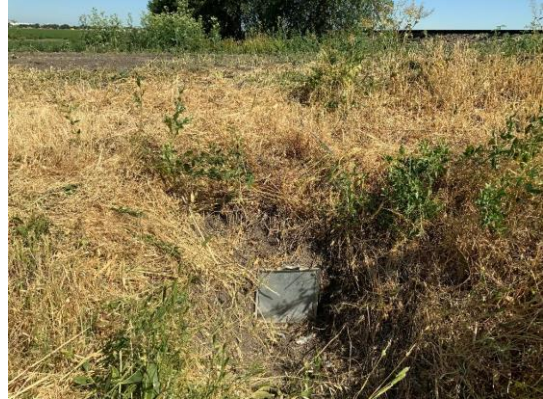
Photo 3 of 3 : UCIP_FA_2022_74381_97063.jpg

WS view: Slope and plate gate at toe.

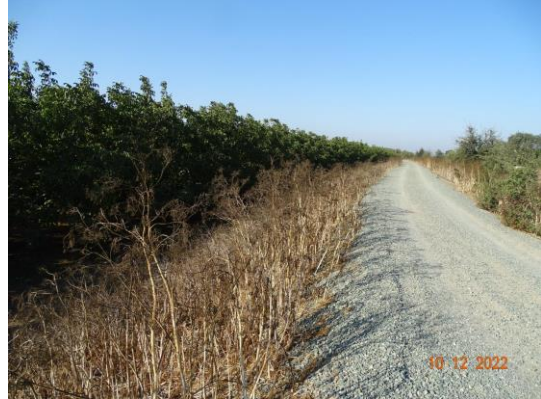
Photo 1 of 1 : FA_2022_NA0017_150_4_20221023_00010.jpg

LM Start	0.24	Rating **	M	Issue No.	4
LM End	0.46	Issue Type +	Ma	Location *	LS
Category	Earthen Levee			GPS Latitude/Longitude	
				Start	End
Item	Vegetation			37.979207 °	37.979306 °
				-121.094561 °	-121.090493 °
DWR ID	DWR_NA0017_06_f _ 2022_4				
Comment Code					
V2 : Remove the wild growth and woody vegetation other than native grasses from the levee slopes.					
Inspector Comment

View of wild growth vegetation along the landside slope and easement. Fall 2022

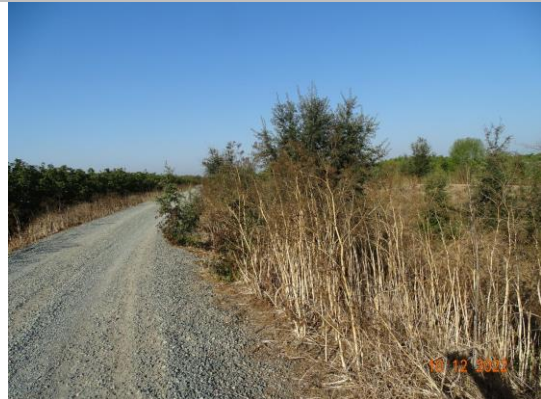
Photo 1 of 1 : FA_2022_NA0017_150_5_20221023_00011.jpg

LM Start	0.24	Rating **	M	Issue No.	5
LM End	0.46	Issue Type +	Ma	Location *	WS
Category	Earthen Levee			GPS Latitude/Longitude	
				Start	End
Item	Vegetation			37.979208 °	37.979289 °
				-121.094561 °	-121.090497 °
DWR ID	DWR_NA0017_06_f_2022_5				
Comment Code					
V2 : Remove the wild growth and woody vegetation other than native grasses from the levee slopes.					
Inspector Comment

View of wild growth vegetation along the waterside slope. Fall 2022

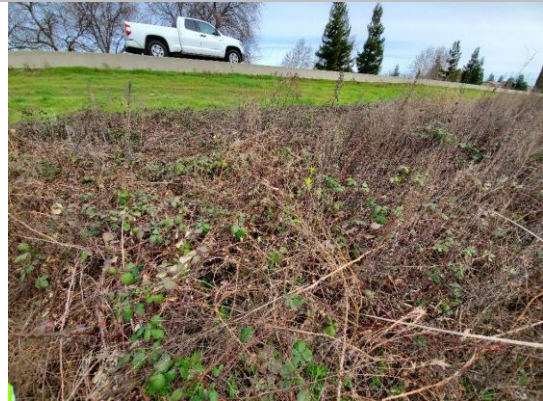
Photo 1 of 3 : UCIP_FA_2022_77188_95618.jpg

Comment Code						
Inspector Comment						
DS_ID:23620 FS_ID:77188 EP_NO: N/A Repair Type: Non-Urgent EVAL Issue: Crossing Status: Not Found UCIP Comments: 02/16/2021 The record has been upgraded from No Action Needed to Non-Urgent. Pipe was not found at the indicated location or surrounding. Dense vegetation at WS toe limited inspection, but no indication of an existing pipe at LS toe with high visibility. DWR DMP geophysical results did not confirm presence of pipe through levee. Record will remain in UCIP's inspection records until future Levee Improvement Project can confirm no crossing was found through the levee. The UCIP inspection was completed with GEI staff, H. Dunn and LMA representative, M. Mccoy. (B. Singh – GEI) FIELD_STRUCT_DESC: 24-inch corrugated metal drainage pipe (CMP) through the levee, 8.8 feet below the crown. Flap gate on the waterside (WS) end. Concrete U-shaped headwall on the WS end. Cobble grouted spillway across berm. [Additional Reference(s): DWR Levee Log, 1976, (HLM 0.67). USACE San Joaquin O&M Manual 612.1, June 1965, (HLM 0.67)]. FS Date: 2/16/2021

WS view: WS slope from WS toe. Dense vegetation limiting view.

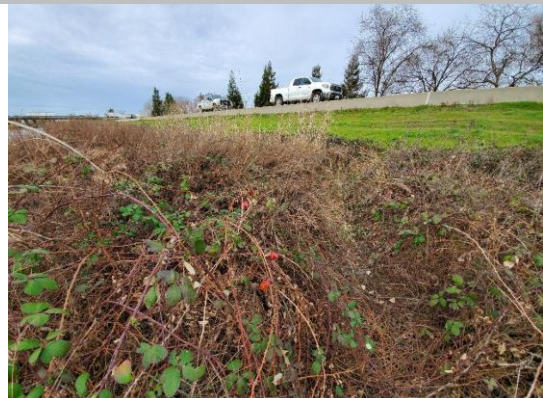
Photo 2 of 3 : UCIP_FA_2022_77188_95619.jpg

WS view: WS slope from toe approximately 30 yards US of indicated location.

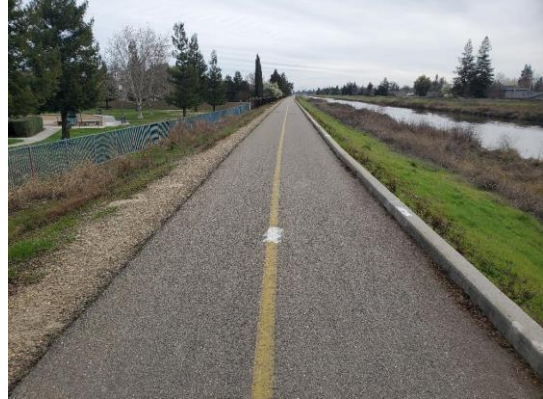
Photo 3 of 3 : UCIP_FA_2022_77188_95620.jpg

Overview of levee crown at indicated location, looking US

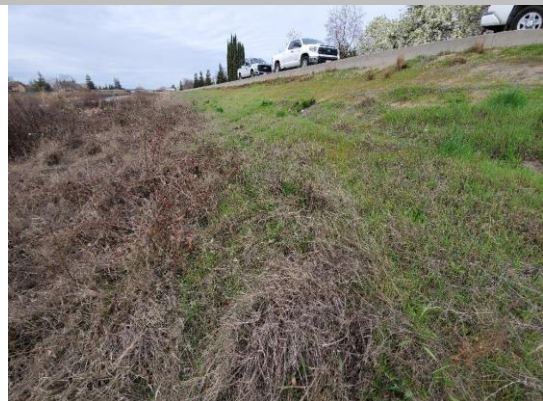
Photo 1 of 3 : UCIP_FA_2022_77190_95644.jpg

DS_ID:23514
 FS_ID:77190
 EP_NO: N/A
 Repair Type: Non-Urgent
 EVAL Issue:
 Crossing Status: Not Found
 UCIP Comments: 02/16/2021 The record has been upgraded from No Action Needed to Non-Urgent. Pipe listed in USACE O&M Manual but was not found in the field. DWR DMP geophysical results did not confirm presence of pipe through levee. Record will remain in UCIP's inspection records until future Levee Improvement Project can confirm no crossing was found through the levee. The UCIP inspection was completed with GEI staff, H. Dunn and LMA representative, M. McCoy. (B. Singh – GEI)
 FIELD_STRUCT_DESC: 24-inch corrugated metal drainage pipe (CMP) through the levee, 8.4 feet below the crown. Flap gate on the waterside (WS) end. Concrete U-shaped headwall on the WS end. Cobble grouted spillway across berm. [Additional Reference(s): DWR Levee Log, 1987, (HLM 0.81). USACE San Joaquin O&M Manual 612.1, June 1965, (HLM 0.81)].

WS view: View DS from WS toe

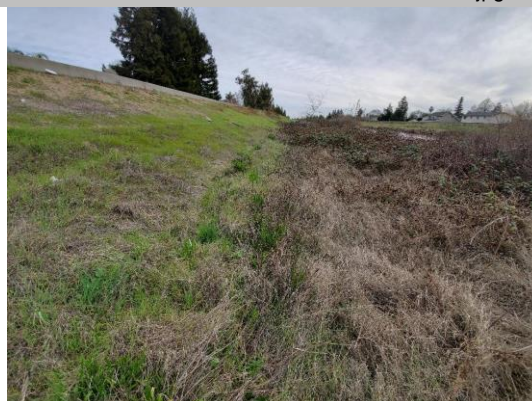
Photo 2 of 3 : UCIP_FA_2022_77190_95645.jpg

WS view: View US from WS toe

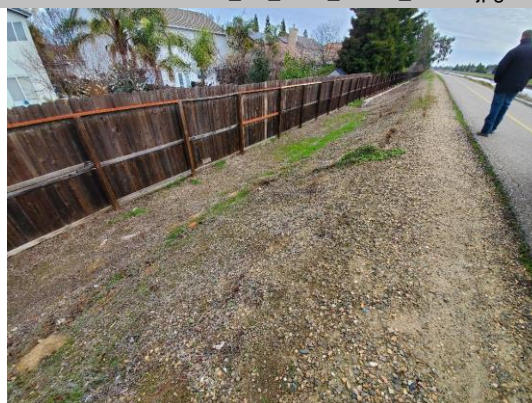
Photo 3 of 3 : UCIP_FA_2022_77190_95646.jpg

LS view: View toward LS toe, looking US

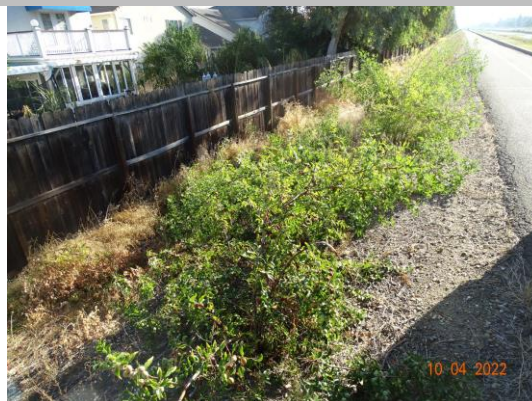
Photo 1 of 1 : FA_2022_NA0017_151_200_20221025_00568.jpg

View of wild vegetation on the landside slope. Fall 2022

LM Start	0.61	Rating **	M	Issue No.	200
LM End	0.61	Issue Type +	Ma	Location *	LS
Category	Earthen Levee			GPS Latitude/Longitude	
				Start	End
Item	Vegetation			38.043520 °	38.043520 °
				-121.362405 °	-121.362405 °
DWR ID	DWR_NA0017_07_f_2022_200				
Comment Code					
V2 : Remove the wild growth and woody vegetation other than native grasses from the levee slopes.					
Inspector Comment

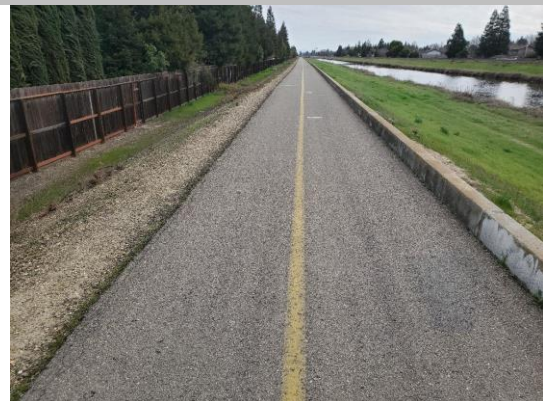
Photo 1 of 3 : UCIP_FA_2022_77191_95685.jpg

Comment Code						
Inspector Comment						
DS_ID:23515 FS_ID:77191 EP_NO: N/A Repair Type: Non-Urgent EVAL Issue: Crossing Status: Not Found UCIP Comments: 02/16/2021 The record has been upgraded from No Action Needed to Non-Urgent. Pipe was not found at indicated or surrounding locations in the field. DWR DMP geophysical results did not confirm presence of pipe through levee. Record will remain in UCIP's inspection records until future Levee Improvement Project can confirm no crossing was found through the levee. The UCIP inspection was completed with GEI staff, H. Dunn and LMA representative, M. Mccoy. (B. Singh – GEI) FIELD_STRUCT_DESC: 24-inch corrugated metal drainage pipe (CMP) through the levee, 8.1 feet below the crown. Flap gate on the waterside (WS) end. Concrete U-shaped headwall on the WS end. Cobble grouted spillway across berm. [Additional Reference(s): DWR Levee Log, 1987, (HLM 0.94). USACE San Joaquin O&M Manual 612.1, June 1965, (HLM 0.94)]. FS Date: 2/16/2021

Overview of levee crown, looking US

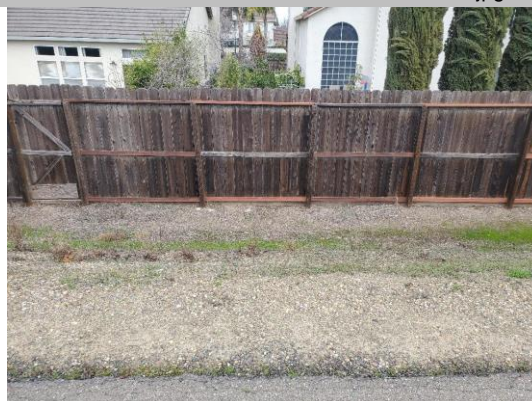
Photo 2 of 3 : UCIP_FA_2022_77191_95686.jpg

LS view: View toward LS toe from levee crown

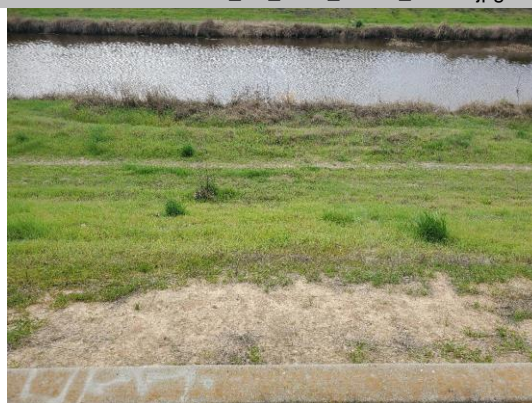
Photo 3 of 3 : UCIP_FA_2022_77191_95687.jpg

WS view: View toward WS toe from levee crown

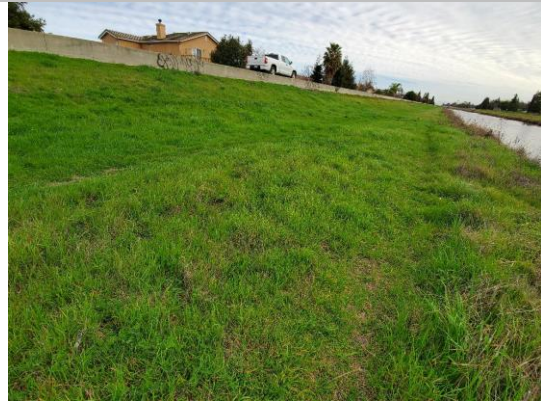
Photo 1 of 3 : UCIP_FA_2022_77192_95693.jpg

Comment Code						
Inspector Comment						
DS_ID:23516 FS_ID:77192 EP_NO: N/A Repair Type: Non-Urgent EVAL Issue: Crossing Status: Not Found UCIP Comments: 02/16/2021 The record has been upgraded from No Action Needed to Non-Urgent. Pipe was not found at indicated or surrounding locations in the field. DWR DMP geophysical results did not confirm presence of pipe through levee. Record will remain in UCIP's inspection records until future Levee Improvement Project can confirm no crossing was found through the levee. The UCIP inspection was completed with GEI staff, H. Dunn and LMA representative, M. Mccoy. (B. Singh – GEI) FIELD_STRUCT_DESC: 24-inch corrugated metal drainage pipe (CMP) through the levee, 7.4 feet below the crown. Flap gate on the waterside (WS) end. Concrete U-shaped headwall on the WS end. Cobble grouted spillway across berm. [Additional Reference(s): DWR Levee Log, 1987, (HLM 1.08). USACE San Joaquin O&M Manual 612.1, June 1965, (HLM 1.08)]. FS Date: 2/16/2021

WS view: View US along WS toe

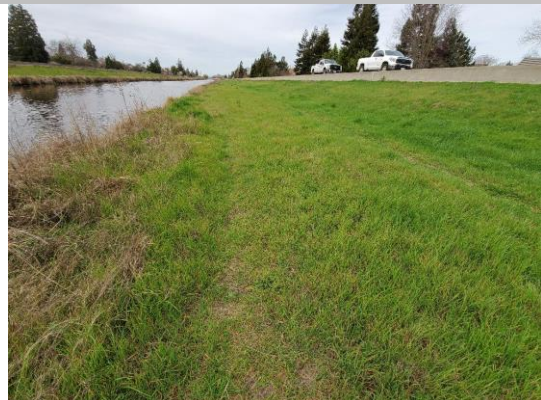
Photo 2 of 3 : UCIP_FA_2022_77192_95694.jpg

WS view: View DS along WS toe

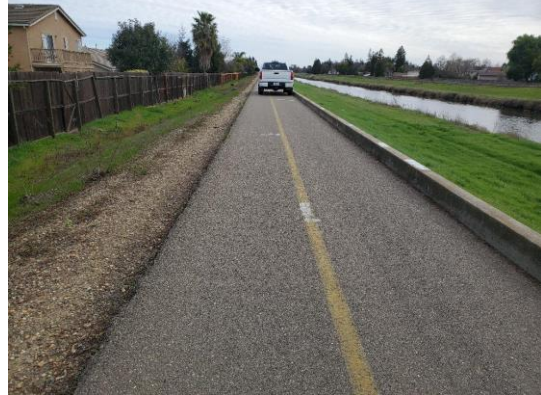
Photo 3 of 3 : UCIP_FA_2022_77192_95695.jpg

Overview of levee crown, looking US

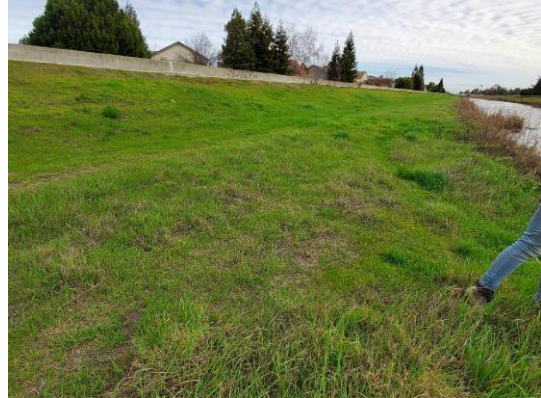
Photo 1 of 3 : UCIP_FA_2022_77193_95702.jpg

DS_ID:23517
 FS_ID:77193
 EP_NO: N/A
 Repair Type: Non-Urgent
 EVAL Issue:
 Crossing Status: Indicator Found
 UCIP Comments: 02/16/2021 The record has been upgraded from No Action Needed to Non-Urgent. Pipe was not found at indicated or surrounding locations in the field. DWR DMP Geophysical study indicates possible presence of pipe through levee. Owner needs to coordinate with the CVFPB to remove or abandon crossing according to Title 23 requirements. Record will remain in UCIP's database and site should be monitored for integrity issues that might arise with buried pipe. No permit was found authorizing this encroachment. CVFPB will need to review crossing to determine owner. The UCIP inspection was completed with GEI staff, H. Dunn and LMA representative, M. McCoy. (B. Singh – GEI)
 FIELD_STRUCT_DESC: 24-inch corrugated metal drainage pipe (CMP) through the levee, 7.2 feet below the crown. Flap gate on the waterside (WS) end. Concrete U-shaped headwall on the WS end. Cobble grouted spillway across berm. [Additional Reference(s): DWR Levee Log, 1987, (HLM 1.22). USACE San Joaquin O&M Manual 612.1, June 1965, (HLM 1.22)].

WS view: View US along WS toe

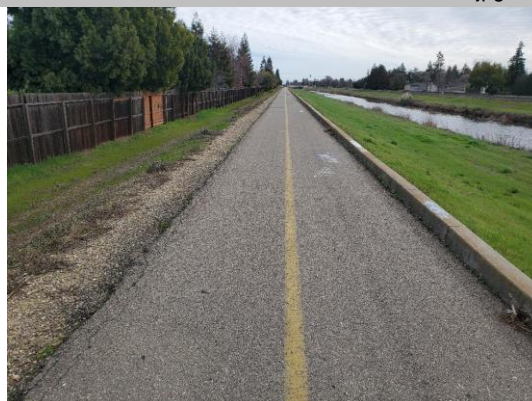
Photo 2 of 3 : UCIP_FA_2022_77193_95703.jpg

Overview of levee crown, looking US

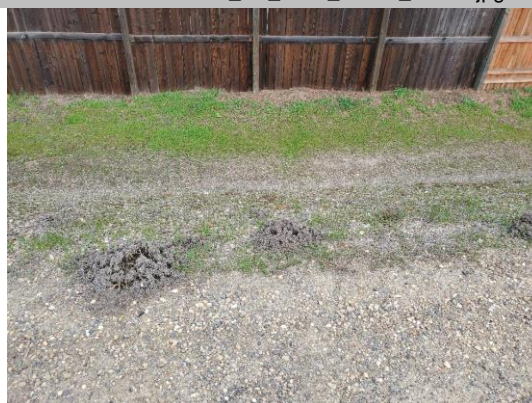
Photo 3 of 3 : UCIP_FA_2022_77193_95704.jpg

LS view: View toward LS toe from levee crown

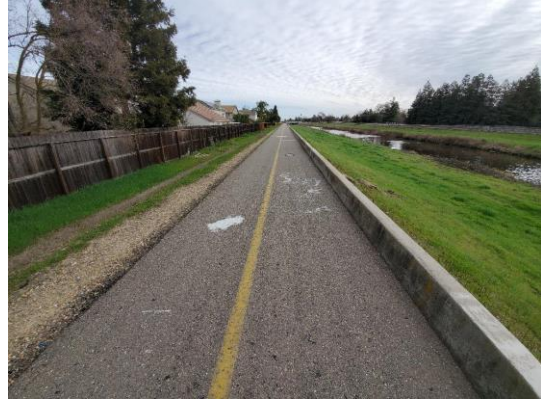
Photo 1 of 3 : UCIP_FA_2022_77194_95711.jpg

Comment Code						
Inspector Comment						
DS_ID:23518 FS_ID:77194 EP_NO: N/A Repair Type: Non-Urgent EVAL Issue: Crossing Status: Indicator Found UCIP Comments: 02/16/2021 The record has been upgraded from No Action Needed to Non-Urgent. Pipe was not found at indicated or surrounding locations in the field. DWR DMP Geophysical study indicates possible presence of pipe through levee. Owner needs to coordinate with the CVFPB to remove or abandon crossing according to Title 23 requirements. Updated coordinates are 38.0432064, -121.3530273. CVFPB will need to review crossing to determine owner. The UCIP inspection was completed with GEI staff, H. Dunn and LMA representative, M. Mccoy. (B. Singh ? GEI) FIELD_STRUCT_DESC: 24-inch corrugated metal drainage pipe (CMP) through the levee, 7.1 feet below the crown. Flap gate on the waterside (WS) end. Concrete U-shaped headwall on the WS end. Cobble grouted spillway across berm. [Additional Reference(s): DWR Levee Log, 1987, (HLM 1.36). USACE San Joaquin O&M Manual 612.1, June 1965, (HLM 1.36)]. FS Date: 2/16/2021

Overview of levee crown, looking US

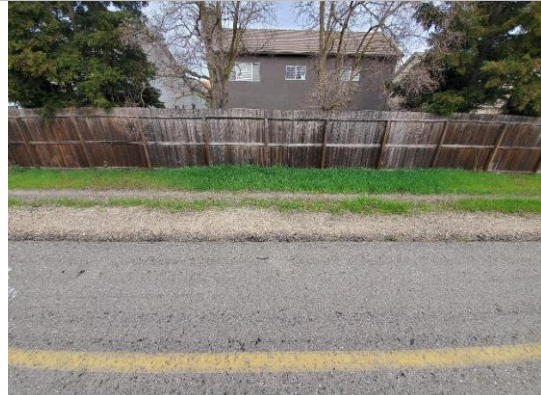
Photo 2 of 3 : UCIP_FA_2022_77194_95712.jpg

LS view: View toward LS toe from levee crown

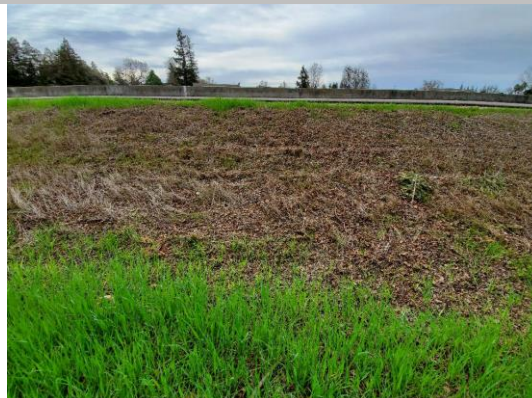
Photo 3 of 3 : UCIP_FA_2022_77194_95713.jpg

LS view: LS slope from LS toe

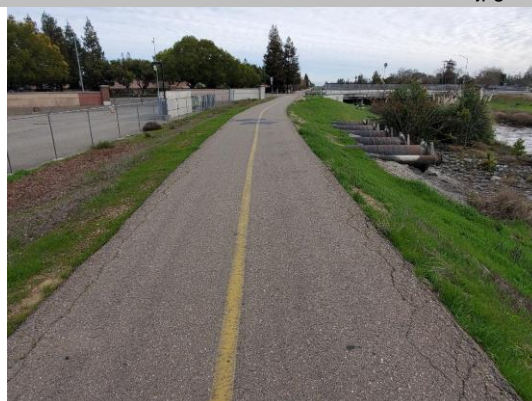
Photo 1 of 3 : UCIP_FA_2022_77196_95727.jpg

DS_ID:23695
 FS_ID:77196
 EP_NO: N/A
 Repair Type: Non-Urgent
 EVAL Issue:
 Crossing Status: Found
 UCIP Comments: 02/16/2021 The record has been upgraded from No Action Needed to Non-Urgent. No permit was found authorizing this encroachment. CVFPB will need to review crossing to determine owner. The UCIP inspection was completed with GEI staff, H. Dunn and LMA representative, M. McCoy. (B. Singh – GEI)
 FIELD_STRUCT_DESC: [Thornton Road Pump Station] 1 of 6: 12-inch wrapped steel storm drainage pipe through the levee, approximately 3.0 feet below the crown. Pump station on the landside (LS). Flap gate on the waterside (WS) end. [Additional Reference(s): USACE San Joaquin O&M Manual 612 (addendum), February 1999, (HLM 2.16), (Station 114+25)].
 FS Date: 2/16/2021

Overview of levee crown, looking US

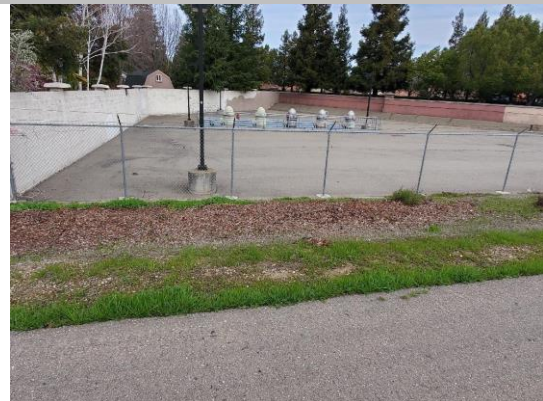
Photo 2 of 3 : UCIP_FA_2022_77197_95734.jpg

LS view: View toward LS toe and pump station from levee crown

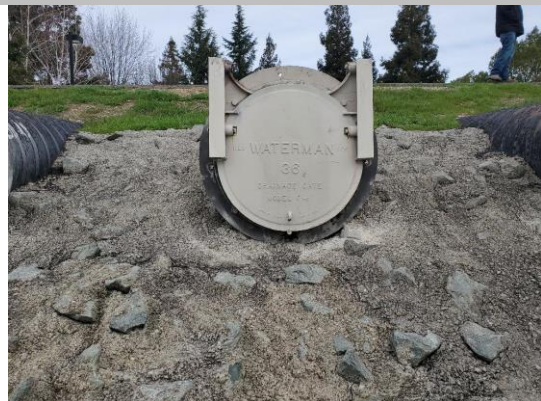
Photo 1 of 3 : UCIP_FA_2022_77198_95739.jpg

DS_ID:23691
 FS_ID:77198
 EP_NO: N/A
 Repair Type: Non-Urgent
 EVAL Issue:
 Crossing Status: Found
 UCIP Comments: 02/16/2021 The record has been upgraded from No Action Needed to Non-Urgent. No permit was found authorizing this encroachment. CVFPB will need to review crossing to determine owner. The UCIP inspection was completed with GEI staff, H. Dunn and LMA representative, M. McCoy. (B. Singh – GEI)
 FIELD_STRUCT_DESC: [Thornton Road Pump Station] 3 of 6: 36-inch wrapped steel storm drainage pipe through the levee, approximately 3.0 feet below the crown. Pump station on the landside (LS). Flap gate on the waterside (WS) end. [Additional Reference(s): USACE San Joaquin O&M Manual 612 (addendum), February 1999, (HLM 2.16), (Station 114+25)].
 FS Date: 2/16/2021

WS view: Pipe at WS toe

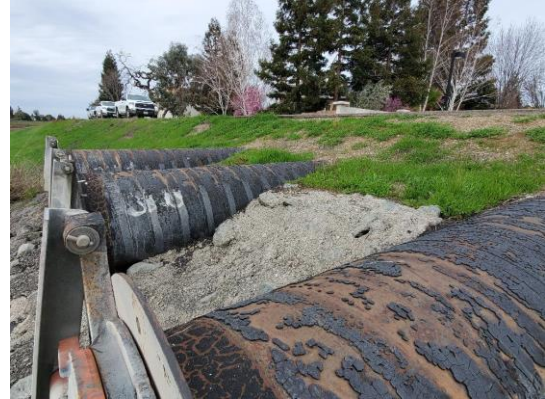
Photo 2 of 3 : UCIP_FA_2022_77198_95740.jpg

WS view: Pipe and WS slope from WS toe

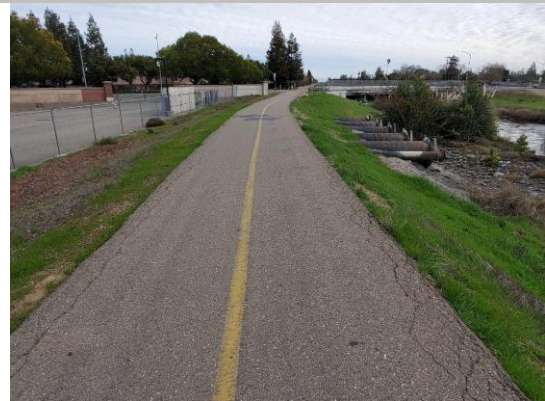
Photo 3 of 3 : UCIP_FA_2022_77198_95741.jpg

Overview of levee crown

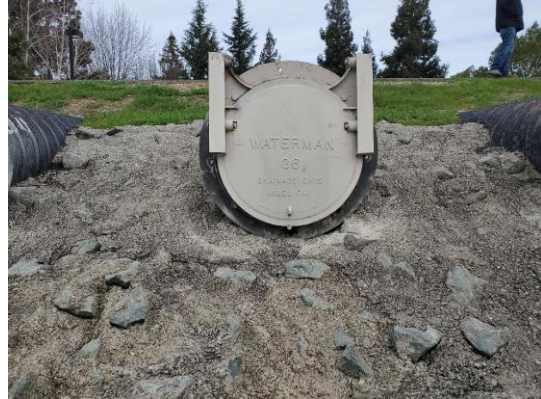
Photo 1 of 3 : UCIP_FA_2022_77199_95745.jpg

Comment Code					
Inspector Comment					
DS_ID:23692 FS_ID:77199 EP_NO: N/A Repair Type: Non-Urgent EVAL Issue: Crossing Status: Found UCIP Comments: 02/16/2021 The record has been upgraded from No Action Needed to Non-Urgent. No permit was found authorizing this encroachment. CVFPB will need to review crossing to determine owner. The UCIP inspection was completed with GEI staff, H. Dunn and LMA representative, M. Mccoy. (B. Singh – GEI) FIELD_STRUCT_DESC: [Thornton Road Pump Station] 4 of 6: 36-inch wrapped steel storm drainage pipe through the levee, approximately 3.0 feet below the crown. Pump station on the landside (LS). Flap gate on the waterside (WS) end. [Additional Reference(s): USACE San Joaquin O&M Manual 612 (addendum), February 1999, (HLM 2.16), (Station 114+25)]. FS Date: 2/16/2021

WS view: Pipe at WS toe

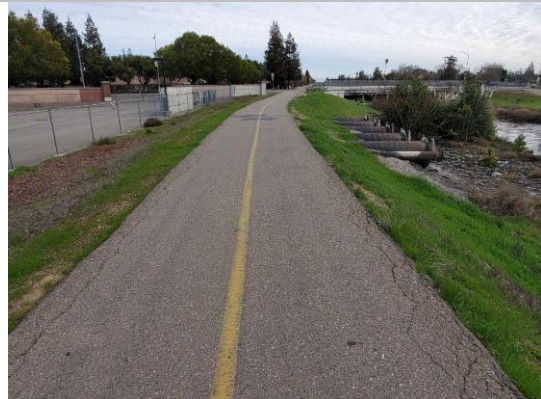
Photo 2 of 3 : UCIP_FA_2022_77199_95746.jpg

Overview of levee crown, looking US
