**Flood Control Project Maintenance
Levee Inspections**

Maintenance Issue Types Only, Levee Inspection Report By Mile - Fall 2022

San Joaquin County Flood Control and Water Conservation District

Waterway	Bank	Unit Miles	Inspection Start/End	Inspector
Unit No. 01 Littlejohn Creek	Left	2.59	10/13/2022 10/13/2022	Alberto De Leon

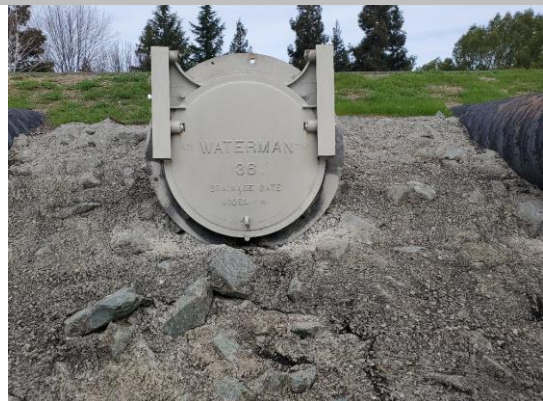
Photo 1 of 3 : UCIP_FA_2022_77200_95749.jpg

DS_ID:23693
 FS_ID:77200
 EP_NO: N/A
 Repair Type: Non-Urgent
 EVAL Issue:
 Crossing Status: Found
 UCIP Comments: 02/16/2021 The record has been upgraded from No Action Needed to Non-Urgent. No permit was found authorizing this encroachment. CVFPB will need to review crossing to determine owner. The UCIP inspection was completed with GEI staff, H. Dunn and LMA representative, M. McCoy. (B. Singh – GEI)
 FIELD_STRUCT_DESC: [Thornton Road Pump Station] 5 of 6: 36-inch wrapped steel storm drainage pipe through the levee, approximately 3.0 feet below the crown. Pump station on the landside (LS). Flap gate on the waterside (WS) end. [Additional Reference(s): USACE San Joaquin O&M Manual 612 (addendum), February 1999, (HLM 2.16), (Station 114+25)].
 FS Date: 2/16/2021

WS view: Pipe at WS toe

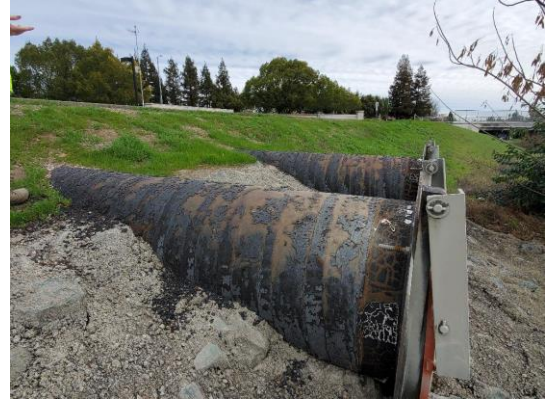
Photo 2 of 3 : UCIP_FA_2022_77200_95750.jpg

WS view: Pipe and slope from WS toe

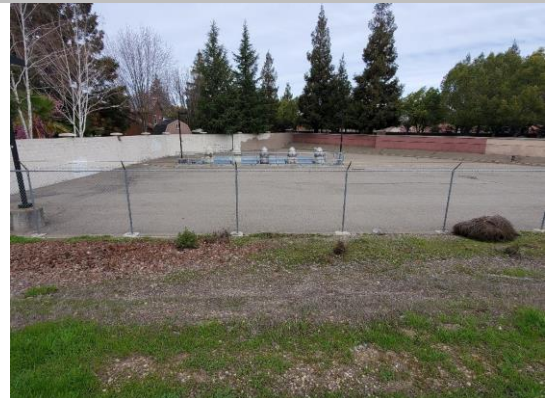
Photo 3 of 3 : UCIP_FA_2022_77200_95751.jpg

LS view: View toward pump station and LS toe from levee crown

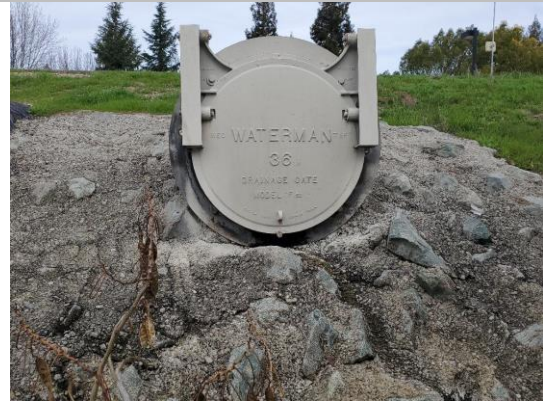
Photo 1 of 3 : UCIP_FA_2022_77201_95755.jpg

Comment Code					
Inspector Comment					
DS_ID:23694 FS_ID:77201 EP_NO: N/A Repair Type: Non-Urgent EVAL Issue: Crossing Status: Found UCIP Comments: 02/16/2021 The record has been upgraded from No Action Needed to Non-Urgent. No permit was found authorizing this encroachment. CVFPB will need to review crossing to determine owner. The UCIP inspection was completed with GEI staff, H. Dunn and LMA representative, M. Mccoy. (B. Singh – GEI) FIELD_STRUCT_DESC: [Thornton Road Pump Station] 6 of 6: 36-inch wrapped steel storm drainage pipe through the levee, approximately 3.0 feet below the crown. Pump station on the landside (LS). Flap gate on the waterside (WS) end. [Additional Reference(s): USACE San Joaquin O&M Manual 612 (addendum), February 1999, (HLM 2.16), (Station 114+25)]. FS Date: 2/16/2021

WS view: Pipe at WS toe

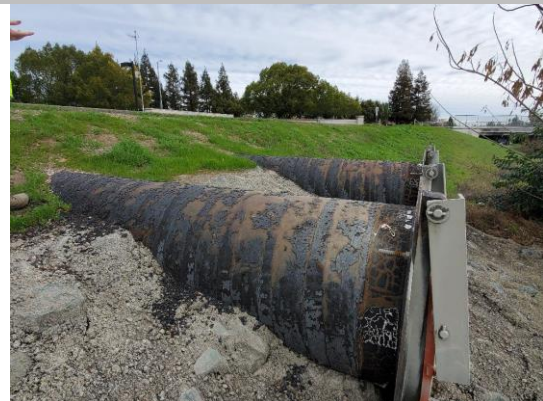
Photo 2 of 3 : UCIP_FA_2022_77201_95756.jpg

WS view: Pipe (right) and WS slope from WS toe

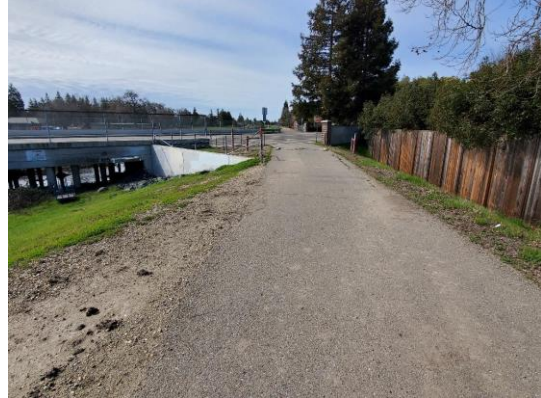
Photo 1 of 2 : UCIP_FA_2022_77207_95778.jpg

DS_ID:23520
 FS_ID:77207
 EP_NO: N/A
 Repair Type: Non-Urgent
 EVAL Issue: 4b, Safety Issue
 Crossing Status: Not Found
 UCIP Comments: 02/16/2021 The record has been upgraded from No Action Needed to Non-Urgent. Inspection was not completed due to housing encampment at site location. Unable to verify presence of crossing. No permit was found authorizing this encroachment. CVFPB will need to review crossing to determine owner. The UCIP inspection was completed with GEI staff, H. Dunn and LMA representative, M. McCoy. (B. Singh – GEI)
 FIELD_STRUCT_DESC: 24-inch corrugated metal drainage pipe (CMP) through the levee, 7.6 feet below the crown. Concrete U-shaped headwall on both ends. Flap gate on the waterside (WS) end. Cobble grouted spillway across the berm. [Additional Reference(s): DWR Levee Log, 1987, (HLM 1.63). USACE San Joaquin O&M Manual 612.1, June 1965, (HLM 1.63)].
 FS Date: 2/16/2021

Overview of levee crown, looking DS

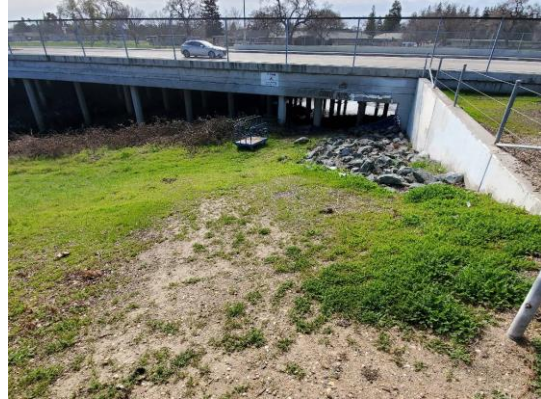
Photo 2 of 2 : UCIP_FA_2022_77207_95779.jpg

WS slope. No indicator found.

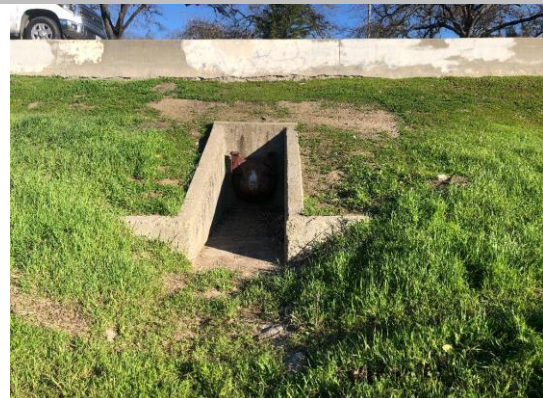
Photo 2 of 3 : UCIP_FA_2022_77212_91081.jpg

WS view: Headwall and flapgate on WS toe.

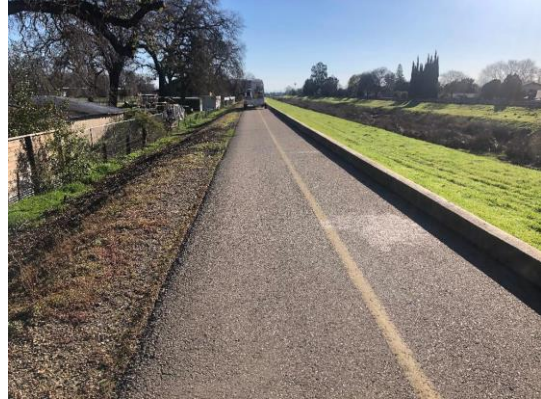
Photo 3 of 3 : UCIP_FA_2022_77212_91082.jpg

Levee crown.

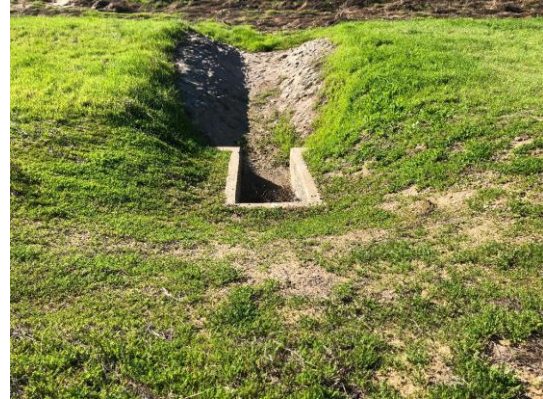
Photo 3 of 3 : UCIP_FA_2022_77213_91087.jpg

LS view: WS headwall at toe from crown.

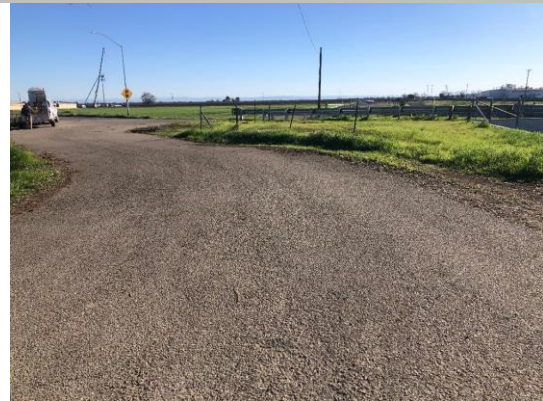
Photo 1 of 3 : UCIP_FA_2022_77216_91140.jpg

DS_ID:23525
 FS_ID:77216
 EP_NO: N/A
 Repair Type: Non-Urgent
 EVAL Issue:
 Crossing Status: Found
 UCIP Comments: 02/17/2021 Record was updated from No Action Needed to Non-Urgent. DWR DMP has not found internal issues, LOF between 1 and 2. Recommend inspection in 5 years. Minor erosion on one edge of the LS headwall. CVFPB will need to review crossing to determine owner. The UCIP inspection was completed with GEI staff, B. Singh, N. Cholewinski, and LMA representative, J. Caruso. (H. Dunn – GEI)
 FIELD_STRUCT_DESC: 24-inch corrugated metal drainage pipe (CMP) through the levee, 8.0 feet below the crown. Concrete U-shaped headwalls on both ends. Flap gate on the waterside (WS) end. Cobble grouted spillway across the berm. [Additional Reference(s): DWR Levee Log, 1987, (HLM 3.09). USACE San Joaquin O&M Manual 612.1, June 1965, (HLM 3.09)].
 FS Date: 2/17/2021

Levee crown looking upstream.

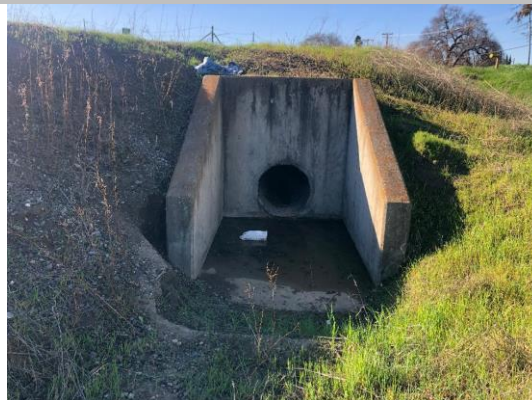
Photo 2 of 3 : UCIP_FA_2022_77216_91141.jpg

LS view: LS headwall at toe. Minor scouring on left side of headwall.

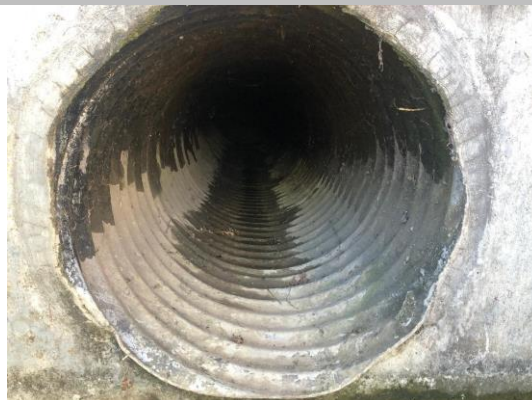
Photo 3 of 3 : UCIP_FA_2022_77216_91142.jpg

LS view: LS pipe.

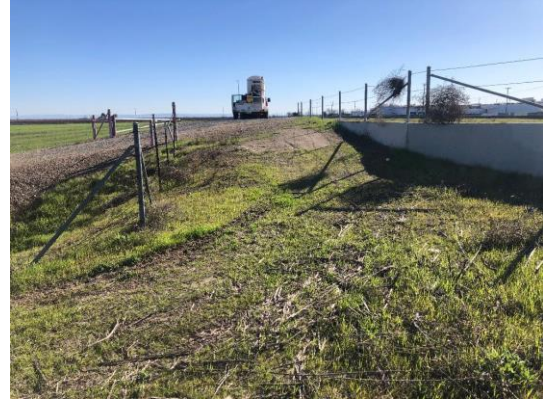
Photo 1 of 3 : UCIP_FA_2022_77218_91156.jpg

Comment Code					
Inspector Comment					
DS_ID:23526 FS_ID:77218 EP_NO: N/A Repair Type: Non-Urgent EVAL Issue: Crossing Status: Found UCIP Comments: 02/17/2021 Record was updated from No Action Needed to Non-Urgent. DWR DMP has not found internal issues, LOF between 1 and 2. Recommend inspection in 5 years. CVFPB will need to review crossing to determine owner. The UCIP inspection was completed with GEI staff, B. Singh, N. Cholewinski, and LMA representative, J. Caruso. (H. Dunn – GEI) FIELD_STRUCT_DESC: 24-inch corrugated metal storm drainage pipe (CMP) through the levee, 7.5 feet below the crown. Concrete U-shaped headwalls on both ends. Flap gate on the waterside (WS) end. Cobble grouted spillway across the berm. [Additional Reference(s): DWR Levee Log, 1987, (HLM 3.11). USACE San Joaquin O&M Manual 612.1, June 1965, (HLM 3.12), and 612 (addendum), February 1999, (HLM 3.15), (Station 166+25)]. FS Date: 2/17/2021

Levee crown looking upstream.

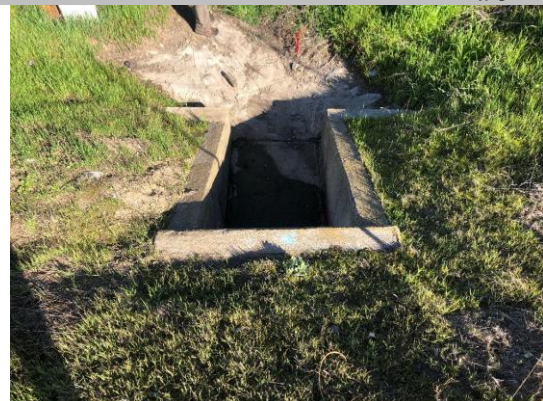
Photo 2 of 3 : UCIP_FA_2022_77218_91157.jpg

LS view: LS headwall at toe from crown.

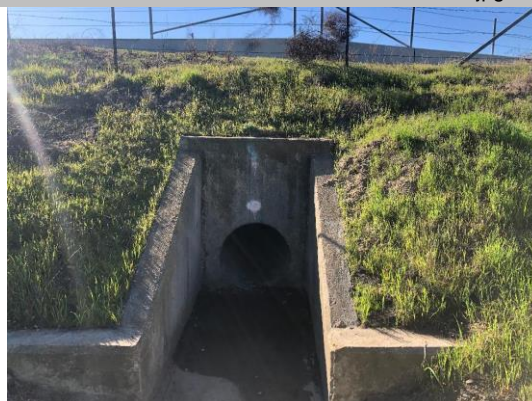
Photo 3 of 3 : UCIP_FA_2022_77218_91158.jpg

LS view: LS headwall at toe.

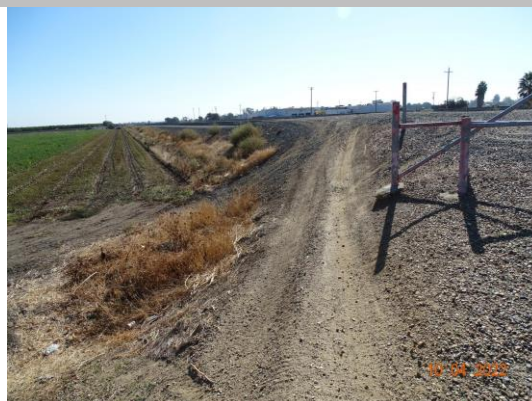
Photo 1 of 1 : FA_2022_NA0017_151_214_20221025_00576.jpg

LM Start	2.83	Rating **	M	Issue No.	214
LM End	2.83	Issue Type +	Ma	Location *	LS
Category	Earthen Levee			GPS Latitude/Longitude	
				Start	End
Item	Erosion / Foot Traffic			38.043219 °	38.043219 °
				-121.321756 °	-121.321756 °
DWR ID	DWR_NA0017_07_f_2022_214				
Comment Code					
E3 : Repair the levee slope damaged by foot traffic and prevent access where possible.					
Inspector Comment

View of erosion on the landside slope caused by pedestrian traffic. Fall 2022

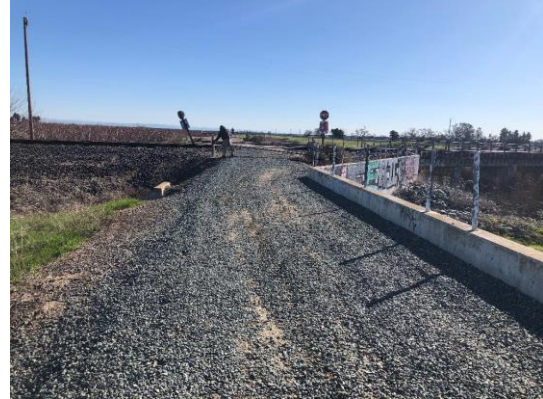
Photo 1 of 3 : UCIP_FA_2022_77219_95478.jpg

Comment Code					
Inspector Comment					
DS_ID:23528 FS_ID:77219 EP_NO: N/A Repair Type: Non-Urgent EVAL Issue: Crossing Status: Found UCIP Comments: 02/17/2021 Record was updated from No Action Needed to Non-Urgent. DWR DMP has not found internal issues, LOF between 1 and 2. Recommend inspection in 5 years. CVFPB will need to review crossing to determine owner. The UCIP inspection was completed with GEI staff, B. Singh, N. Cholewinski, and LMA representative, J. Caruso. (H. Dunn – GEI) FIELD_STRUCT_DESC: 42-inch corrugated metal drainage pipe (CMP) through the levee, 7.3 feet below the crown. Concrete U-shaped headwall on both sides. Flap gate on the waterside (WS) end. Grouted intake on the landside (LS). Cobble grouted spillway across the berm. [Additional Reference(s): DWR Levee Log, 1987, (HLM 3.36). USACE San Joaquin O&M Manual 612.1, June 1965, (HLM 3.36)]. FS Date: 2/17/2021

Levee crown looking upstream.

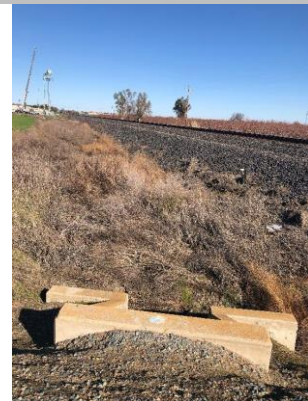
Photo 2 of 3 : UCIP_FA_2022_77219_95479.jpg

LS View: Headwall at toe from crown.

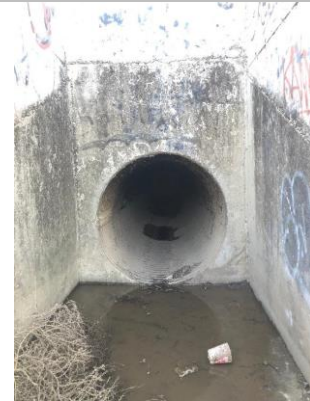
Photo 3 of 3 : UCIP_FA_2022_77219_95480.jpg

LS View: Pipe inlet.

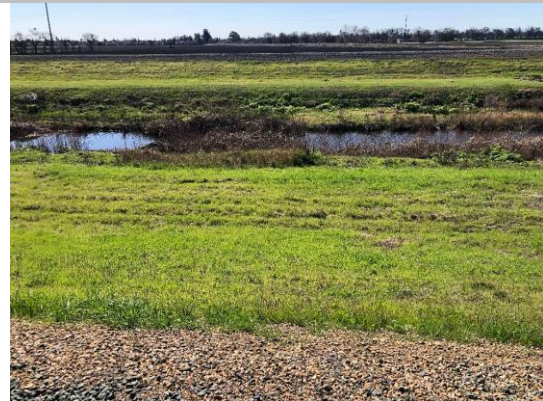
Photo 1 of 3 : UCIP_FA_2022_77223_93643.jpg

DS_ID:23651
 FS_ID:77223
 EP_NO: N/A
 Repair Type: Non-Urgent
 EVAL Issue:
 Crossing Status: Not Found
 UCIP Comments: 02/17/2021 The record has been upgraded from No Action Needed to Non-Urgent. Pipe not found by visual inspection. DWR DMP geophysical study did not confirm presence of pipe through levee. Record will remain in UCIP's inspection records until future Levee Improvement Project can confirm no crossing was found through the levee. No permit was found authorizing this encroachment. CVFPB will need to review crossing to determine owner. The UCIP inspection was completed with GEI staff, B. Singh, N. Cholewinski, and LMA representative, J. Caruso. (H. Dunn – GEI)
 FIELD_STRUCT_DESC: 24-inch storm drainage pipe of an unknown material through the levee, at an unknown depth. [Additional Reference(s): USACE San Joaquin O&M Manual 612 (addendum), February 1999, (HLM 3.48), (Station 183+50)].
 FS Date: 2/17/2021

WS toe from crown, no pipe visible.

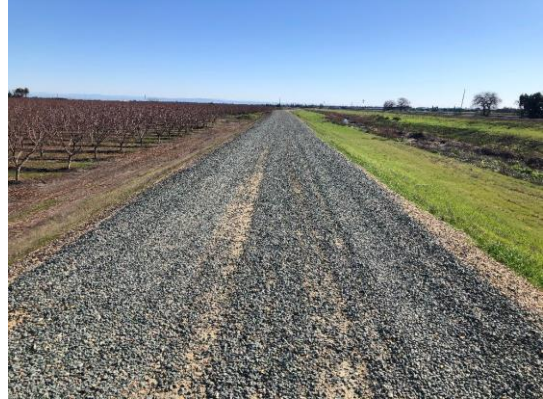
Photo 2 of 3 : UCIP_FA_2022_77223_93644.jpg

Levee crown looking upstream.

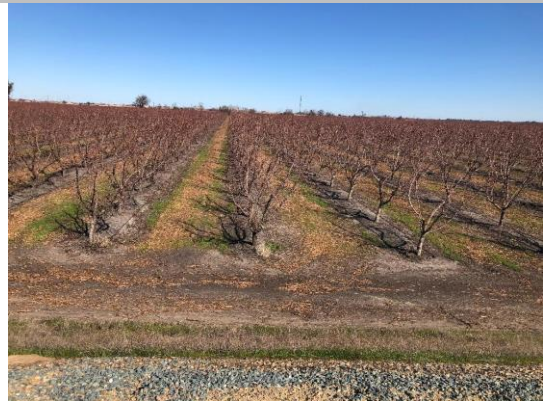
Photo 3 of 3 : UCIP_FA_2022_77223_93645.jpg

LS toe from crown, no pipe visible.

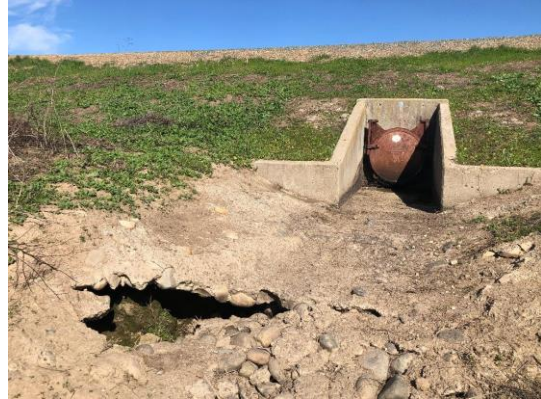
Photo 1 of 3 : UCIP_FA_2022_77225_93666.jpg

Comment Code						
Inspector Comment						
DS_ID:23532 FS_ID:77225 EP_NO: N/A Repair Type: Non-Urgent EVAL Issue: 5, Pipe Damage Crossing Status: Found UCIP Comments: 02/17/2021 The record has been upgraded from No Action Needed to Non-Urgent. DWR DMP has found integrity issues, LOF between 4 and 5. Crossing will be monitored until funding becomes available for rehabilitation. Minor erosion underneath the grouted WS spillway. 2 feet in length, half foot in height. No permit was found authorizing this encroachment. CVFPB will need to review crossing to determine owner. The UCIP inspection was completed with GEI staff, B. Singh, N. Cholewinski, and LMA representative, J. Caruso. (H. Dunn – GEI) FIELD_STRUCT_DESC: 36-inch corrugated metal drainage pipe (CMP) through the levee, 8.5 feet below the crown. Concrete U-shaped headwalls on both ends. Flap gate on the waterside (WS) end. Cobble grouted spillway across berm. [Additional Reference(s): DWR Levee Log, 1987, (HLM 3.58). USACE San Joaquin O&M Manual 612.1, June 1965, (HLM 3.58)]. FS Date: 2/17/2021

WS headwall and flapgate at toe. Minor erosion underneath grouted spillway.

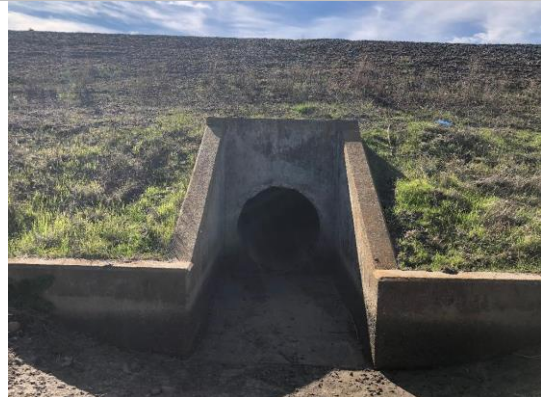
Photo 2 of 3 : UCIP_FA_2022_77225_93662.jpg

LS view: LS headwall at toe.

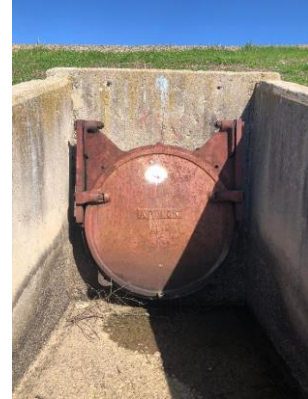
Photo 3 of 3 : UCIP_FA_2022_77225_95505.jpg

WS view: Headwall and close up view of flapgate.

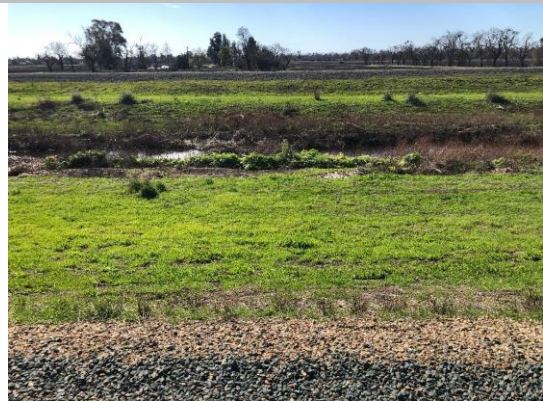
Photo 1 of 3 : UCIP_FA_2022_77226_93668.jpg

DS_ID:23652
 FS_ID:77226
 EP_NO: N/A
 Repair Type: Non-Urgent
 EVAL Issue:
 Crossing Status: Not Found
 UCIP Comments: 02/17/2021 The record has been upgraded from No Action Needed to Non-Urgent. Pipe not found by visual inspection. DWR DMP geophysical study did not confirm presence of pipe through levee. Record will remain in UCIP's inspection records until future Levee Improvement Project can confirm no crossing was found through the levee. No permit was found authorizing this encroachment. CVFPB will need to review crossing to determine owner. The UCIP inspection was completed with GEI staff, B. Singh, N. Cholewinski, and LMA representative, J. Caruso. (H. Dunn – GEI)
 FIELD_STRUCT_DESC: 24-inch storm drainage pipe of an unknown material through the levee, at an unknown depth. [Additional Reference(s): USACE San Joaquin O&M Manual 612 (addendum), February 1999, (HLM 3.63), (Station 192+15)].
 FS Date: 2/17/2021

WS toe from crown, pipe not visible.

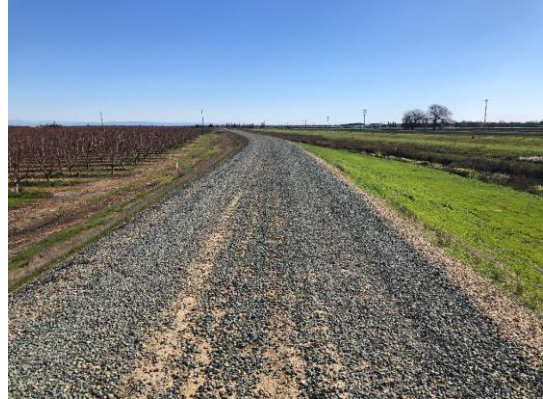
Photo 2 of 3 : UCIP_FA_2022_77226_93669.jpg

Levee crown looking upstream.

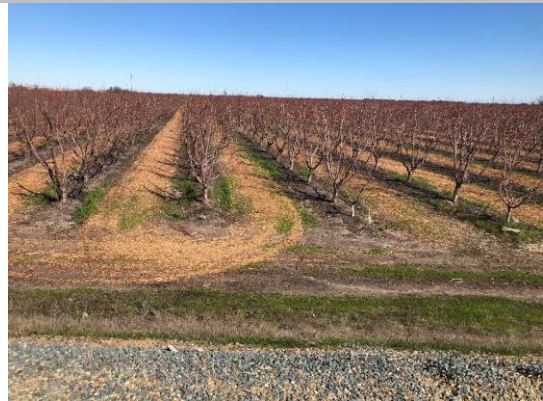
Photo 3 of 3 : UCIP_FA_2022_77226_93670.jpg

LS toe from crown, no pipe visible.

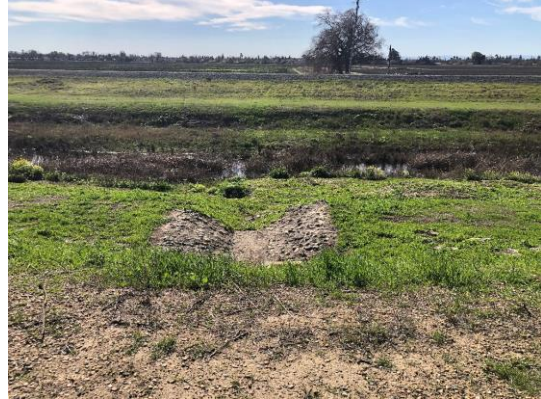
Photo 1 of 3 : UCIP_FA_2022_77228_93682.jpg

Comment Code						
Inspector Comment						
DS_ID:23533 FS_ID:77228 EP_NO: N/A Repair Type: Non-Urgent EVAL Issue: Crossing Status: Found UCIP Comments: 02/17/2021 The record has been upgraded from No Action Needed to Non-Urgent. DWR DMP has not found internal issues, LOF between 1 and 2. Recommend inspection in 5 years. No permit was found authorizing this encroachment. CVFPB will need to review crossing to determine owner. The UCIP inspection was completed with GEI staff, B. Singh, N. Cholewinski, and LMA representative, J. Caruso. (H. Dunn – GEI) FIELD_STRUCT_DESC: 24-inch corrugated metal drainage pipe (CMP) through the levee, 7.0 feet below the crown. Concrete U-shaped headwalls on both ends. Flap gate on the waterside (WS) end. Slide gate on the landside (LS) end. Grouted intake on the LS. Cobble grouted spillway across berm. [Additional Reference(s): DWR Levee Log, 1987, (HLM 3.81). USACE San Joaquin O&M Manual 612.1, June 1965, (HLM 3.81)]. FS Date: 2/17/2021

WS view: WS headwall at toe from crown.

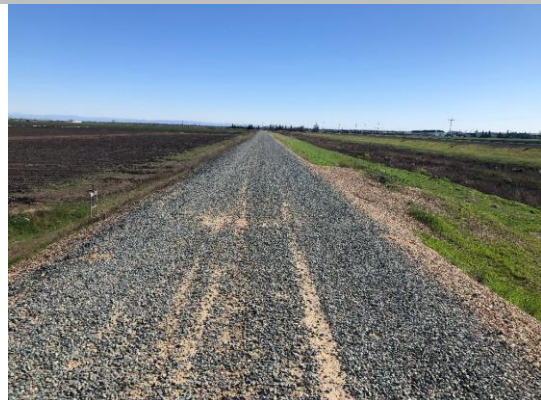
Photo 2 of 3 : UCIP_FA_2022_77228_93684.jpg

Levee crown looking upstream.

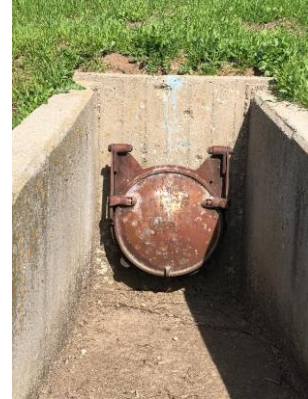
Photo 3 of 3 : UCIP_FA_2022_77228_95513.jpg

WS view: Headwall and close up of flapgate.

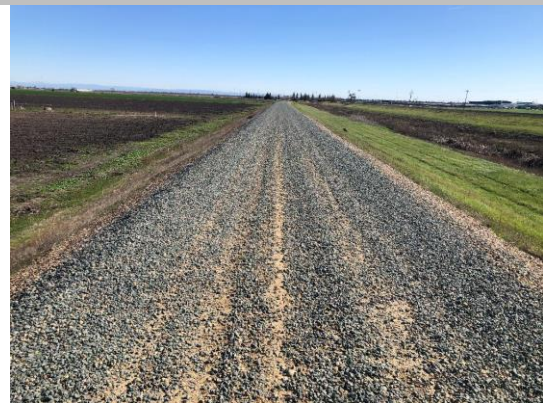
Photo 1 of 3 : UCIP_FA_2022_77229_93689.jpg

DS_ID:23654
 FS_ID:77229
 EP_NO: N/A
 Repair Type: Non-Urgent
 EVAL Issue:
 Crossing Status: Not Found
 UCIP Comments: 02/17/2021 The record has been upgraded from No Action Needed to Non-Urgent. Pipe not found by visual inspection. DWR DMP geophysical study did not confirm presence of pipe through levee. Record will remain in UCIP's inspection records until future Levee Improvement Project can confirm no crossing was found through the levee. No permit was found authorizing this encroachment. CVFPB will need to review crossing to determine owner. The UCIP inspection was completed with GEI staff, B. Singh, N. Cholewinski, and LMA representative, J. Caruso. (H. Dunn – GEI)
 FIELD_STRUCT_DESC: 42-inch culvert of an unknown material for railroad drainage ditch through the levee, at an unknown depth.
 [Additional Reference(s): USACE San Joaquin O&M Manual 612 (addendum), February 1999, (HLM 3.90), (Station 206+00)].

Levee crown looking upstream.

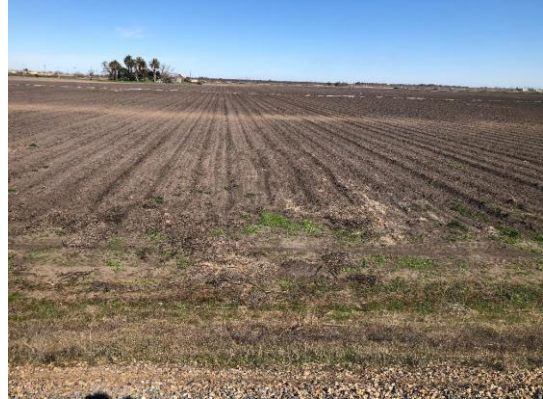
Photo 2 of 3 : UCIP_FA_2022_77229_93690.jpg

LS view: LS toe from crown, no pipe visible.

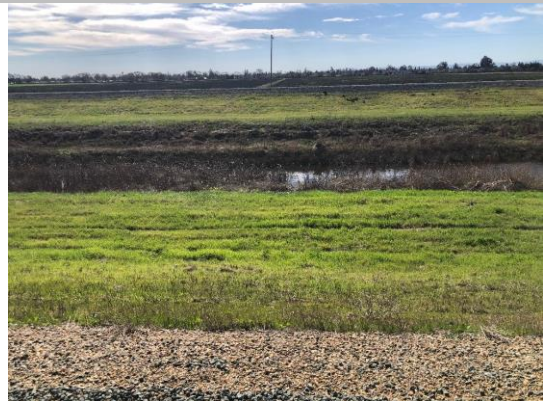
Photo 3 of 3 : UCIP_FA_2022_77229_93691.jpg

WS view: WS toe from crown, no pipe visible.

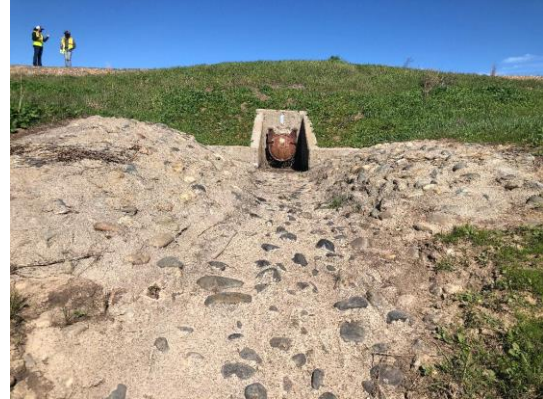
Photo 1 of 3 : UCIP_FA_2022_77232_93717.jpg

Comment Code						
Inspector Comment						
DS_ID:23534 FS_ID:77232 EP_NO: N/A Repair Type: Urgent EVAL Issue: 1, Pipe Integrity Crossing Status: Found UCIP Comments: 02/17/2021 The record has been upgraded from No Action Needed to Urgent. DWR DMP has found integrity issues, LOF between 5 and 6. Crossing will be monitored until funding becomes available to be addressed. Holes and peeling of metal on the inside bottom of the LS pipe. Recommend LMA create contingency plan for increased inspections during high-water. No permit was found authorizing this encroachment. CVFPB will need to review crossing to determine owner. The UCIP inspection was completed with GEI staff, B. Singh, N. Cholewinski, and LMA representative, J. Caruso. (H. Dunn – GEI) FIELD_STRUCT_DESC: 24-inch corrugated metal storm drainage pipe (CMP) through the levee, 7.0 feet below the crown. Concrete U-shaped headwalls on both ends. Flap gate on the waterside (WS) end. Slide gate on the landside (LS) end. Grouted intake on the LS. Cobble grouted spillway across the berm. [Additional Reference(s): DWR Levee Log, 1987, (HLM 4.10). USACE San Joaquin O&M Manual 612.1, June 1965, (HLM 4.10), and 612 (addendum), February 1999, (HLM 4.10), (Station 216+43)]. FS Date: 2/17/2021

WS view: WS headwall and flapgate at toe.

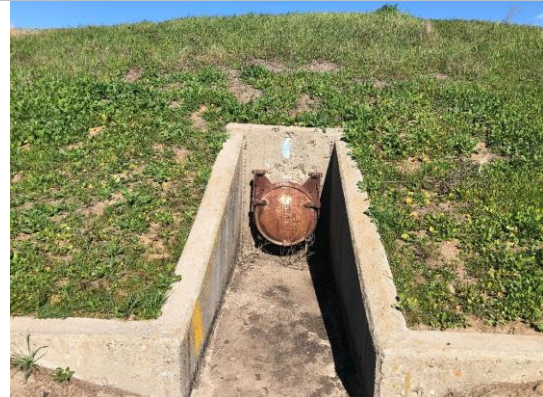
Photo 2 of 3 : UCIP_FA_2022_77232_93718.jpg

WS view: WS headwall and flapgate at toe.

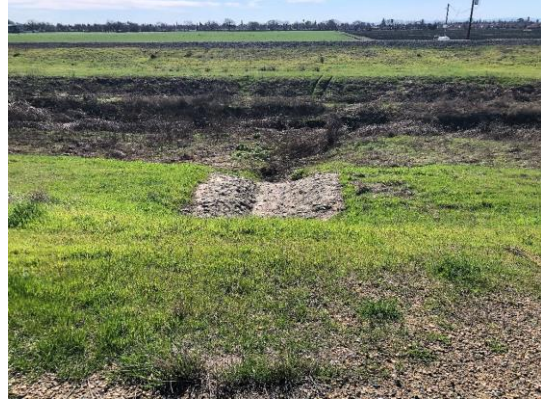
Photo 3 of 3 : UCIP_FA_2022_77232_93719.jpg

WS view: WS headwall at toe from crown.

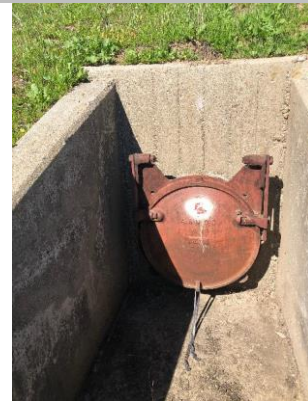
Photo 1 of 3 : UCIP_FA_2022_77234_95535.jpg

DS_ID:23535
 FS_ID:77234
 EP_NO: N/A
 Repair Type: Urgent
 EVAL Issue: 1, Pipe Integrity
 Crossing Status: Found
 UCIP Comments: 02/17/2021 The record has been upgraded from No Action Needed to Urgent. DWR DMP has found integrity issues, LOF between 5 and 6. Crossing will be monitored until funding becomes available to be addressed. Recommend LMA to prepare contingency plan for increased inspections during high-water. No permit was found authorizing this encroachment. CVFPB will need to review crossing to determine owner. The UCIP inspection was completed with GEI staff, B. Singh, N. Cholewinski, and LMA representative, J. Caruso. (H. Dunn – GEI)
 FIELD_STRUCT_DESC: 24-inch corrugated metal storm drainage pipe (CMP) through the levee, 8.0 feet below the crown. Concrete U-shaped headwalls on both ends. Flap gate on the waterside (WS) end. Grouted intake on the landside (LS). Cobble grouted spillway across the berm. [Additional Reference(s): DWR Levee Log, 1987, (HLM 4.37). USACE San Joaquin O&M Manual 612.1, June 1965, (HLM 4.37), and 612 (addendum), February 1999, (HLM 4.33), (Station 228+58)].

WS view: Headwall and close up of flapgate.

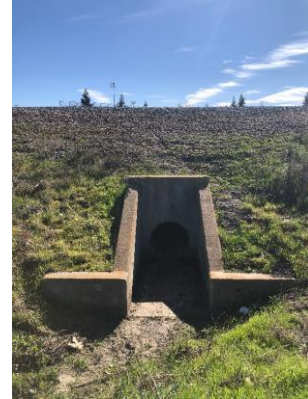
Photo 2 of 3 : UCIP_FA_2022_77234_95536.jpg

LS view: Headwall at toe.

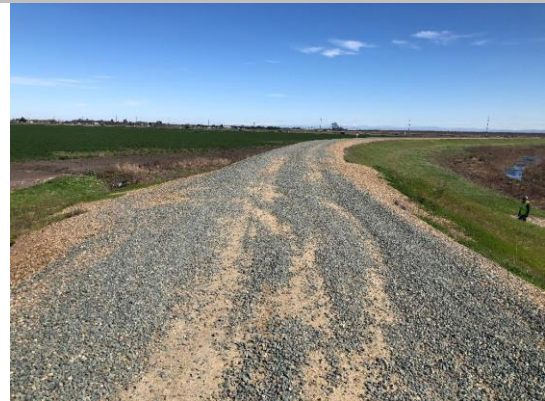
Photo 3 of 3 : UCIP_FA_2022_77234_93735.jpg

Levee crown looking upstream.

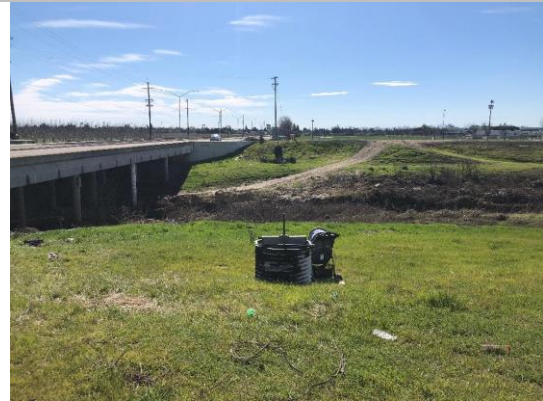
Photo 1 of 3 : UCIP_FA_2022_77235_93742.jpg

Comment Code						
Inspector Comment						
DS_ID:23536 FS_ID:77235 EP_NO: N/A Repair Type: Non-Urgent EVAL Issue: 4b, Safety Issue Crossing Status: Found UCIP Comments: 02/17/2021 The record has been upgraded from No Action Needed to Non-Urgent. LS concrete liner around riser is cracked and misaligned, as well as no cover. DWR DMP Geophysical study indicates possible presence of pipe through levee at 38.0444641, -121.2956106, coordinates have been updated. Owner needs to coordinate with the CVFPB to remove or abandon crossing according to Title 23 requirements. No permit was found authorizing this encroachment. CVFPB will need to review crossing to determine owner. The UCIP inspection was completed with GEI staff, B. Singh, N. Cholewinski, and LMA representative, J. Caruso. (H. Dunn – GEI) FIELD_STRUCT_DESC: 24-inch corrugated metal pipe (CMP) siphon through the levee, 10.4 feet below the crown. Slide gate in a 36-inch CMP riser unit on the waterside (WS) slope. Siphon cleanout in center of channel. Slide gate in concrete standpipe at the landside (LS) toe. [Additional Reference(s): DWR Levee Log, 1987, (HLM 4.62). USACE San Joaquin O&M Manual 612.1, June 1965, (HLM 4.62), and 612 (addendum), February 1999, (HLM 4.62), (Station 243+84)]. FS Date: 2/17/2021

WS view: WS toe from crown, metal riser with slidegate.

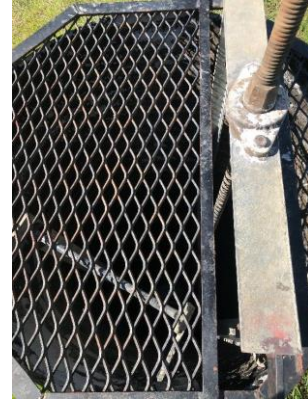
Photo 3 of 3 : UCIP_FA_2022_77235_95547.jpg

WS view: Inside metal riser with slidegate.

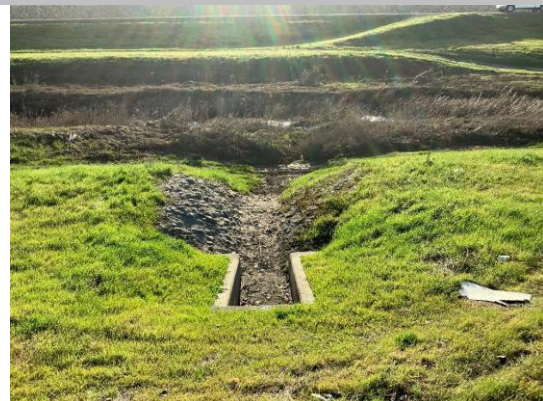
Photo 1 of 3 : UCIP_FA_2022_77239_91205.jpg

DS_ID:23538
 FS_ID:77239
 EP_NO: N/A
 Repair Type: Non-Urgent
 EVAL Issue:
 Crossing Status: Found
 UCIP Comments: 02/18/2021 The record has been upgraded from No Action Needed to Non-Urgent. DWR DMP has not found internal issues, LOF between 1 and 2. Recommend inspection in 5 years. True location was around 20 feet south, coordinates have been updated to 38.0450489. -121.2950334. No permit was found authorizing this encroachment. CVFPB will need to review crossing to determine owner. The UCIP inspection was completed with GEI staff, B. Singh and LMA representative, M. McCoy. (H. Dunn – GEI)
 FIELD_STRUCT_DESC: 24-inch corrugated metal drainage pipe (CMP) through the levee, 8.3 feet below the crown. Concrete U-shaped headwalls on both ends. Flap gate on the waterside (WS) end. Grouted intake on the landside (LS). Cobble grouted spillway across berm. [Additional Reference(s): DWR Levee Log, 1987, (HLM 4.65). USACE San Joaquin O&M Manual 612.1, June 1965, (HLM 4.66)].

WS view: WS headwall at toe from crown.

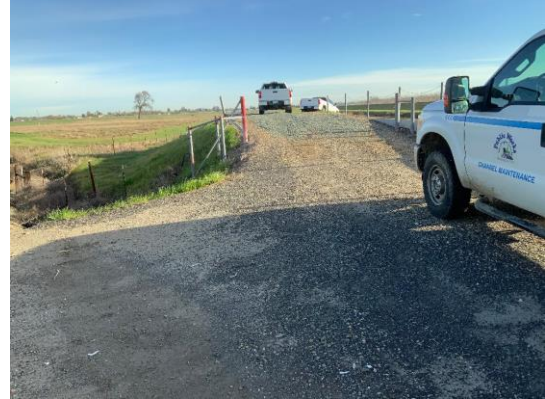
Photo 2 of 3 : UCIP_FA_2022_77239_91206.jpg

Levee crown looking upstream.

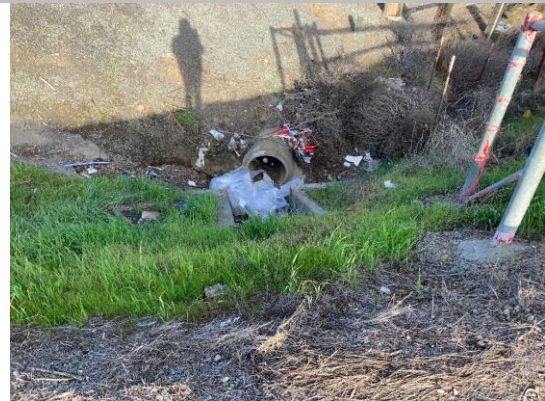
Photo 3 of 3 : UCIP_FA_2022_77239_91207.jpg

LS view: LS headwall at toe from crown.

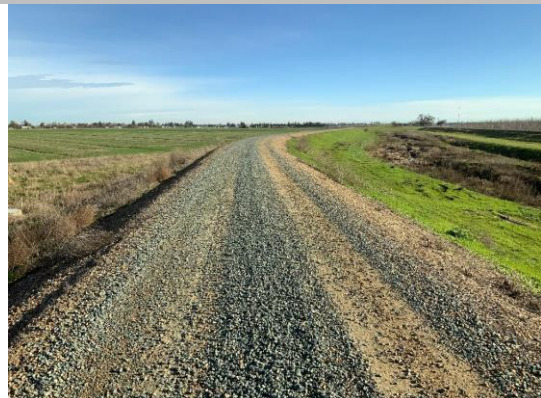
Photo 2 of 3 : UCIP_FA_2022_77241_91230.jpg

Levee crown looking upstream.

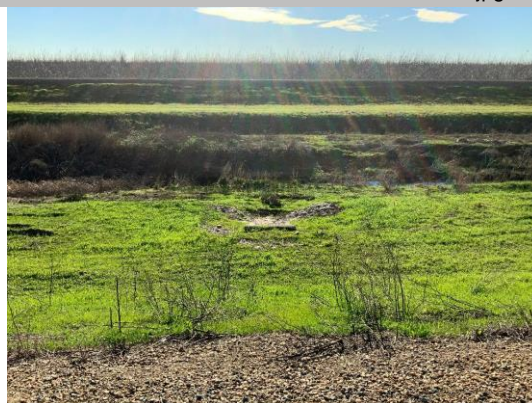
Photo 3 of 3 : UCIP_FA_2022_77241_91231.jpg

WS view: Headwall at WS toe from crown.

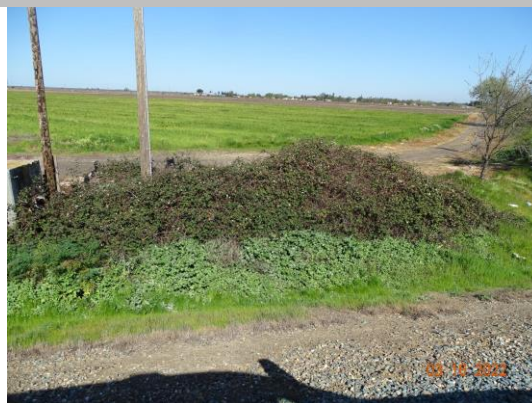
Photo 1 of 1 : FA_2022_NA0017_151_241_20220919_00025.jpg

LM Start	4.94	Rating **	U	Issue No.	241
LM End	4.94	Issue Type +	Ma	Location *	LS
Category	Earthen Levee			GPS Latitude/Longitude	
				Start	End
Item	Vegetation			38.050361 °	38.050361 °
				-121.286959 °	-121.286959 °
DWR ID	DWR_NA0017_07_s_2022_241				
Comment Code					
V2 : Remove the wild growth and woody vegetation other than native grasses from the levee slopes.					
Inspector Comment

There is dense wild vegetation within the landside easement. Spring 2022

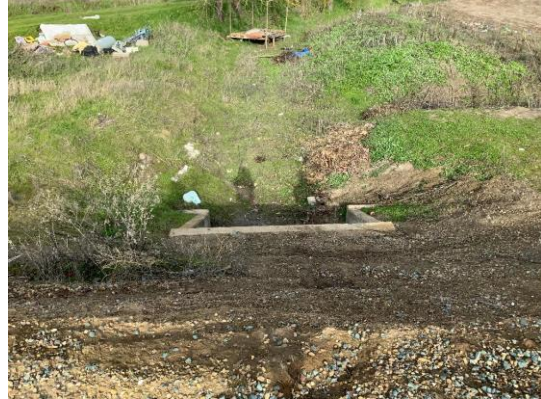
Photo 1 of 3 : UCIP_FA_2022_77246_91293.jpg

Comment Code						
Inspector Comment						
DS_ID:23543 FS_ID:77246 EP_NO: N/A Repair Type: Non-Urgent EVAL Issue: 5, Pipe Damage Crossing Status: Found UCIP Comments: 02/18/2021 The record has been upgraded from No Action Needed to Non-Urgent. DWR DMP has found integrity issues, LOF between 4 and 5. Crossing will be monitored until funding becomes available for rehabilitation. No permit was found authorizing this encroachment. CVFPB will need to review crossing to determine owner. The UCIP inspection was completed with GEI staff, B. Singh and LMA representative, M. McCoy. (H. Dunn – GEI) FIELD_STRUCT_DESC: 1 of 2: 36-inch corrugated metal storm drainage pipe (CMP) through the levee, 8.9 feet below the crown. Concrete U-shaped headwall on both ends. Flap gate on the waterside (WS) end. Grouted intake on the landside (LS). Cobble grouted spillway across the berm. [Additional Reference(s): DWR Levee Log, 1987, (HLM 5.33). USACE San Joaquin O&M Manual 612.1, June 1965, (HLM 5.33), and 612 (addendum), February 1999, (HLM 5.37), (Station 283+76)]. FS Date: 2/18/2021

LS view: LS headwall at toe from crown.

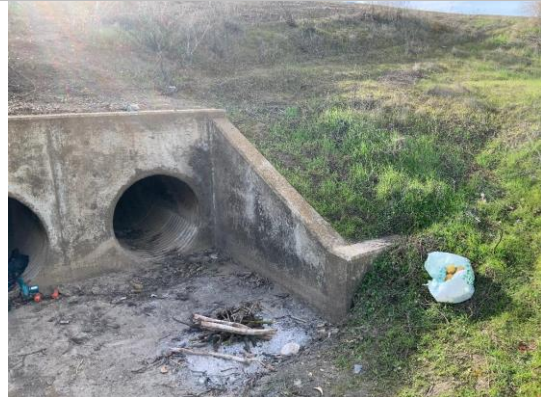
Photo 2 of 3 : UCIP_FA_2022_77246_91294.jpg

LS view: Left side headwall and pipe on LS toe.

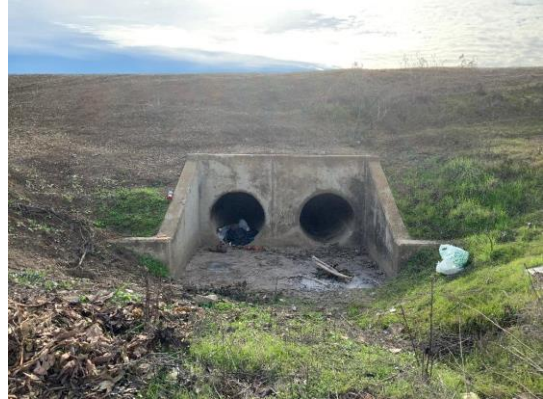
Photo 2 of 3 : UCIP_FA_2022_77247_91400.jpg

LS view: LS headwall and pipes at toe.

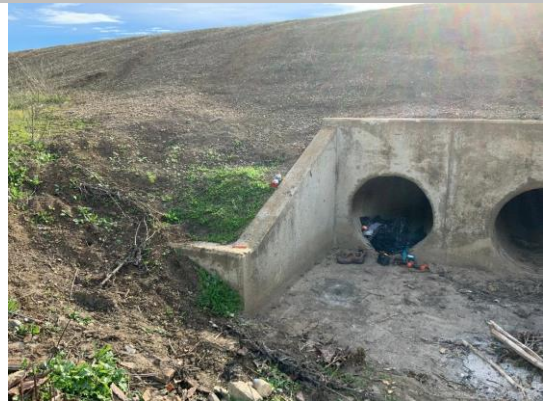
Photo 3 of 3 : UCIP_FA_2022_77247_91402.jpg

LS view: LS headwall and pipe at toe.

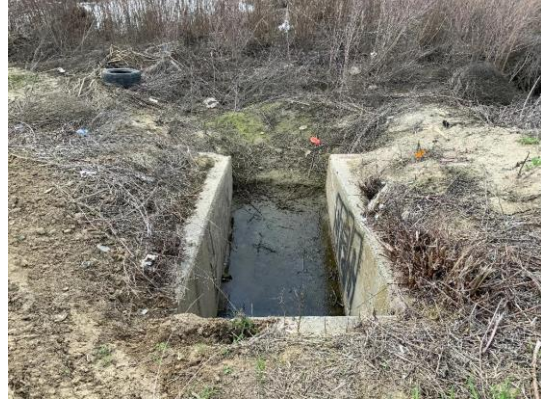
Photo 1 of 3 : UCIP_FA_2022_77248_91418.jpg

Comment Code						
Inspector Comment						
DS_ID:23544 FS_ID:77248 EP_NO: N/A Repair Type: Urgent EVAL Issue: 1, Pipe Integrity Crossing Status: Found UCIP Comments: 02/18/2021 The record has been upgraded from No Action Needed to Urgent. Outside edges of WS pipe are warped with minor erosion on WS slope along pipe alignment. DWR DMP has found integrity issues, LOF between 5 and 6. Crossing will be monitored until funding becomes available to address. No permit was found authorizing this encroachment. CVFPB will need to review crossing to determine owner. The UCIP inspection was completed with GEI staff, B. Singh and LMA representative, M. Mccoy. (H. Dunn – GEI) FIELD_STRUCT_DESC: 36-inch corrugated metal storm drainage pipe (CMP) through the levee, 10.6 feet below the crown. Concrete U-shaped headwall on the waterside (WS) end. Flap gate on the WS end. Cobble grouted spillway across the berm. [Additional Reference(s): DWR Levee Log, 1987, (HLM 5.87). USACE San Joaquin O&M Manual 612.1, June 1965, (HLM 5.87), and 612 (addendum), February 1999, (HLM 5.81), (Station 306+88)]. FS Date: 2/18/2021

WS view: WS headwall at toe from crown.

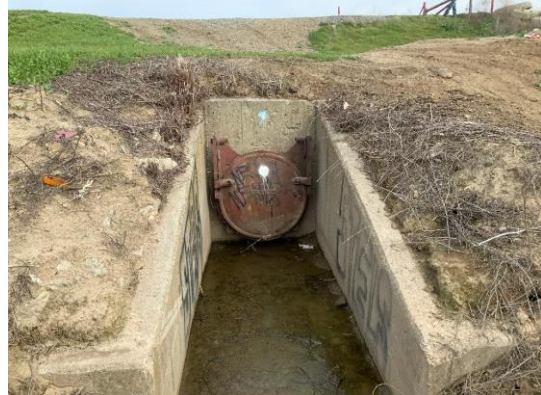
Photo 2 of 3 : UCIP_FA_2022_77248_91419.jpg

WS view: WS headwall and flagate at toe.

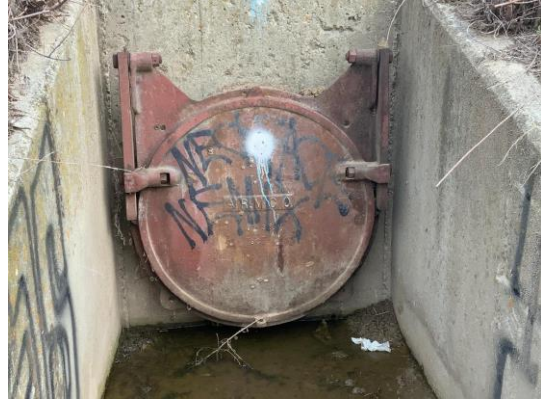
Photo 3 of 3 : UCIP_FA_2022_77248_91415.jpg

WS view: WS flapgate.

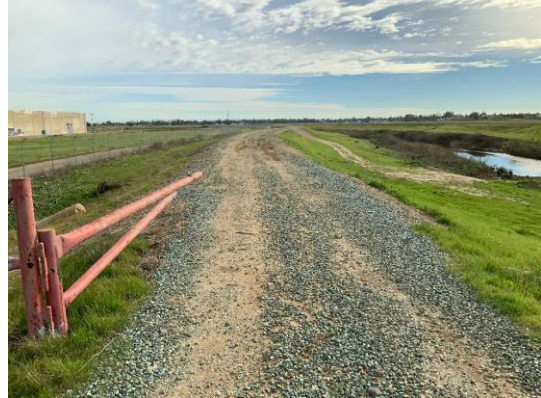
Photo 1 of 3 : UCIP_FA_2022_77251_91732.jpg

Levee crown looking upstream.

Comment Code					
Inspector Comment					
DS_ID:23545 FS_ID:77251 EP_NO: N/A Repair Type: Non-Urgent EVAL Issue: 5, Pipe Damage Crossing Status: Found UCIP Comments: 02/18/2021 Pipe status is still Non-Urgent. Bullet holes seen through LS flapgate compromising effectiveness. LMA stated they would have the holes welded shut within 2 years. DWR DMP has found integrity issues, LOF between 4 and 5. Crossing will be monitored until funding becomes available for rehabilitation. No permit was found authorizing this encroachment. CVFPB will need to review crossing to determine owner. The UCIP inspection was completed with GEI staff, B. Singh and LMA representative, M. McCoy. (H. Dunn – GEI) 05/15/2014 Some sediment buildup inside pipe. (W. Wylie - DWR UCIP) FIELD_STRUCT_DESC: 24-inch corrugated metal drainage pipe (CMP) through the levee, 6.9 feet below the crown. Concrete U-shaped headwalls on both ends. Flap gate on the waterside (WS) end. Grouted intake on the landside (LS). Cobble grouted spillway across berm. [Additional Reference(s): DWR Levee Log, 1987, (HLM 5.90). USACE San Joaquin O&M Manual 612.1, June 1965, (HLM 5.90)]. FS Date: 2/18/2021

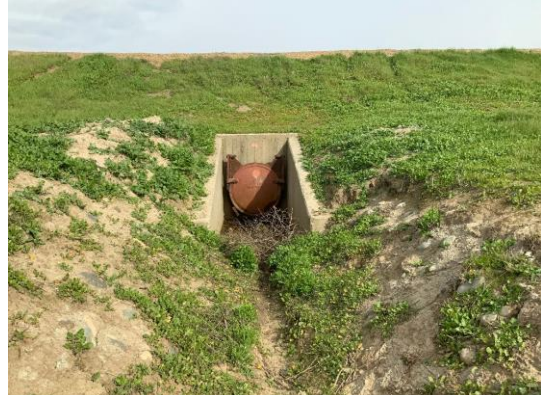
Photo 2 of 3 : UCIP_FA_2022_77252_91740.jpg

WS view: WS headwall and flapgate at toe.

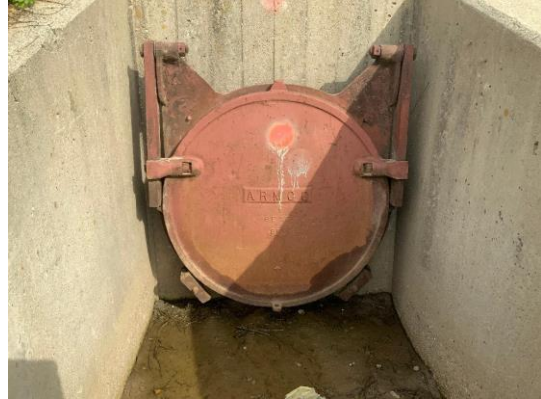
Photo 3 of 3 : UCIP_FA_2022_77252_91737.jpg

WS view: WS flapgate at toe.

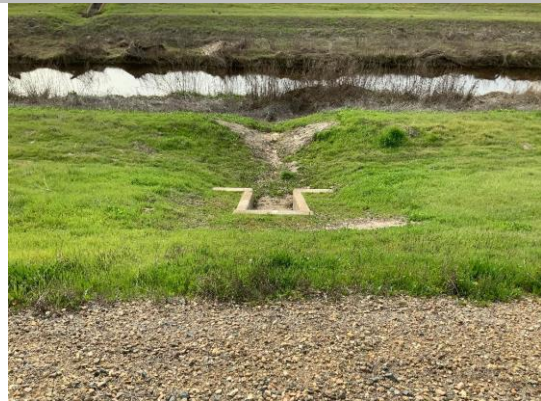
Photo 1 of 3 : UCIP_FA_2022_77261_91770.jpg

DS_ID:23550
 FS_ID:77261
 EP_NO: N/A
 Repair Type: Urgent
 EVAL Issue: 1, Pipe Integrity
 Crossing Status: Found
 UCIP Comments: 02/18/2021 The record has been upgraded from No Action Needed to Urgent. DWR DMP has found integrity issues, LOF between 5 and 6. Crossing will be monitored until funding becomes available for it to be addressed. No permit was found authorizing this encroachment. CVFPB will need to review crossing to determine owner. The UCIP inspection was completed with GEI staff, B. Singh and LMA representative, M. McCoy. (H. Dunn – GEI)
 FIELD_STRUCT_DESC: 24-inch corrugated metal drainage pipe (CMP) through the levee, 5.9 feet below the crown. Concrete U-shaped headwalls on both ends. Flap gate on the waterside (WS) end. Grouted intake on the landside (LS). Cobble grouted spillway across the berm.
 [Additional Reference(s): DWR Levee Log, 1987, (HLM 6.20). USACE San Joaquin O&M Manual 612.1, June 1965, (HLM 6.20)].

WS view: WS headwall at toe from crown.

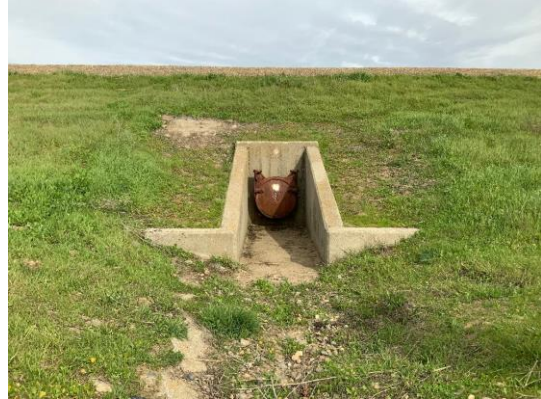
Photo 2 of 3 : UCIP_FA_2022_77261_91771.jpg

WS view: WS headwall and flapgate at toe.

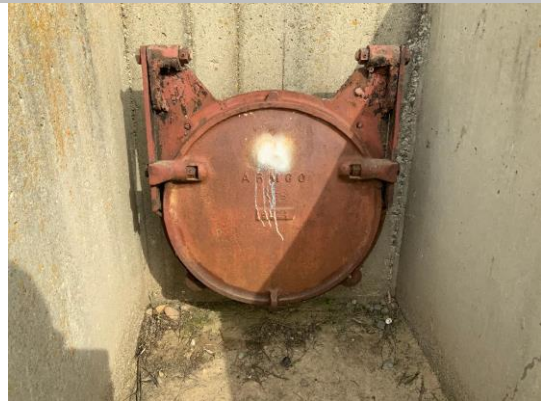
Photo 3 of 3 : UCIP_FA_2022_77261_91772.jpg

WS view: WS flapgate at toe.

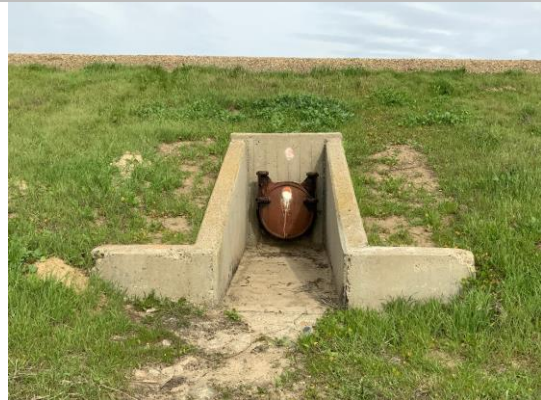
Photo 2 of 3 : UCIP_FA_2022_77262_91778.jpg

WS view: WS headwall and flapgate at toe.

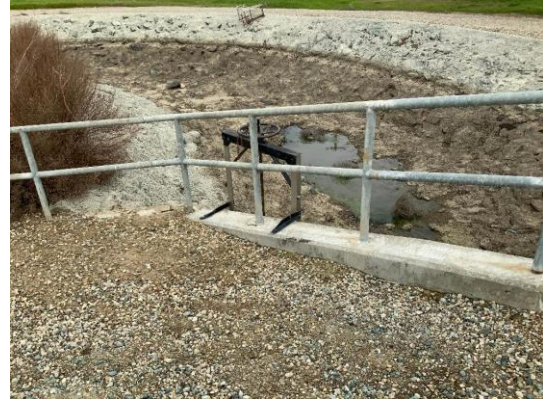
Photo 1 of 3 : UCIP_FA_2022_77266_91804.jpg

Comment Code						
Inspector Comment						
DS_ID:23552 FS_ID:77266 EP_NO: N/A Repair Type: Non-Urgent EVAL Issue: 6, Levee Damage or Threat for Levee Damage Crossing Status: Found UCIP Comments: 02/18/2021 The record has been upgraded from No Action Needed to Non-Urgent. DWR DMP has not found internal issues, LOF between 1 and 2. Recommend inspection in 5 years. Cracking in soil on WS berm (4 feet), recommend monitoring area for material loss. No permit was found authorizing this encroachment. CVFPB will need to review crossing to determine owner. The UCIP inspection was completed with GEI staff, B. Singh and LMA representative, M. Mccoy. (H. Dunn – GEI) FIELD_STRUCT_DESC: 24-inch corrugated metal storm drainage pipe (CMP) through the levee, 6.4 feet below the crown. Concrete U-shaped headwall on the waterside (WS) end. Flap gate on the WS end. Cobble grouted spillway across the berm. Slide gate on the landside (LS) end. [Additional Reference(s): DWR Levee Log, 1987, (HLM 6.51). USACE San Joaquin O&M Manual 612.1, June 1965, (HLM 6.51), and 612 (addendum), February 1999, (HLM 6.51), (Station 343+82)]. FS Date: 2/18/2021

LS view: LS headwall at toe from crown.

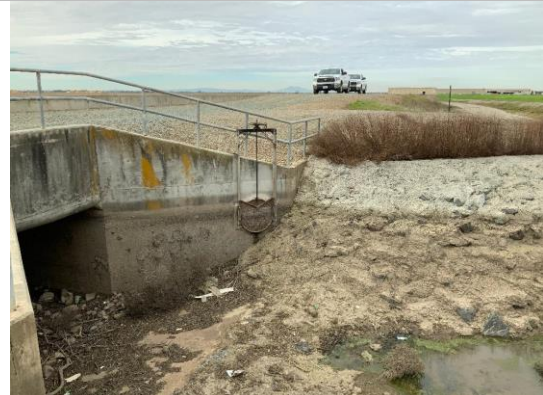
Photo 2 of 3 : UCIP_FA_2022_77266_91805.jpg

LS view: LS headwall and slide gate at toe.

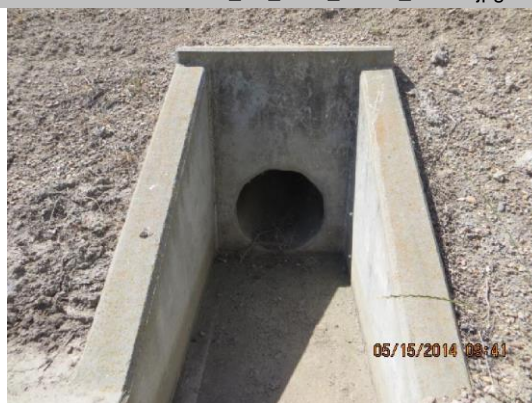
Photo 3 of 3 : UCIP_FA_2022_77268_68871.jpg

Headwall on LS toe.

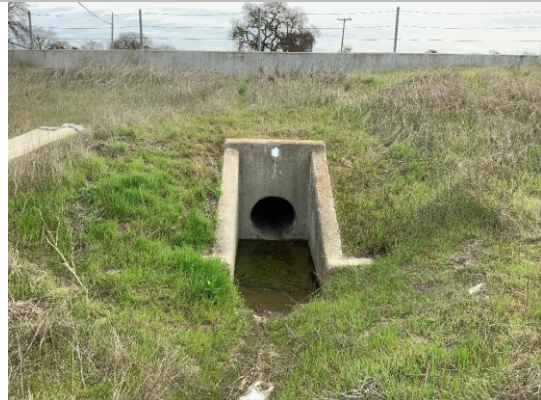
Photo 2 of 3 : UCIP_FA_2022_77271_91835.jpg

LS view: LS headwall at toe.

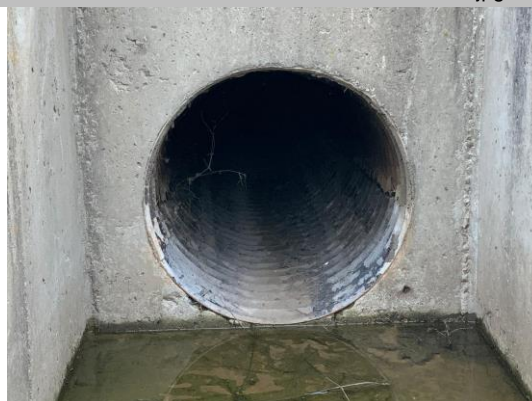
Photo 3 of 3 : UCIP_FA_2022_77271_91836.jpg

LS view: LS pipe.

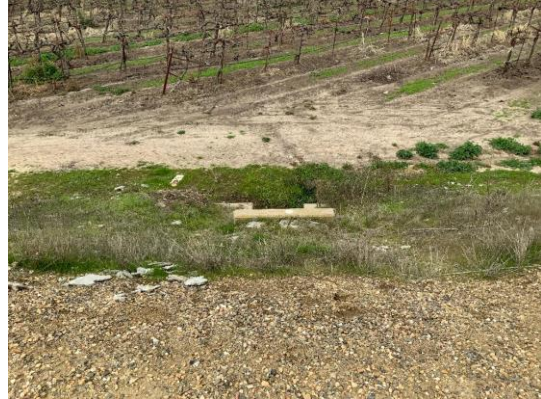
Photo 1 of 3 : UCIP_FA_2022_77274_91851.jpg

Comment Code						
Inspector Comment						
DS_ID:23557 FS_ID:77274 EP_NO: N/A Repair Type: Non-Urgent EVAL Issue: 5, Pipe Damage Crossing Status: Found UCIP Comments: 02/18/2021 The record has been upgraded from No Action Needed to Non-Urgent. DWR DMP has found integrity issues, LOF between 4 and 5. Crossing will be monitored until funding becomes available for rehabilitation. No permit was found authorizing this encroachment. CVFPB will need to review crossing to determine owner. The UCIP inspection was completed with GEI staff, B. Singh and LMA representative, M. Mccoy. (H. Dunn – GEI) FIELD_STRUCT_DESC: 24-inch corrugated metal storm drainage pipe (CMP) through the levee, 6.5 feet below the crown. Concrete U-shaped headwalls on both ends. Flap gate on the waterside (WS) end. Cobble grouted spillway across the berm. Culvert with slide gate in headwall on the WS. [Additional Reference(s): DWR Levee Log, 1987, (HLM 7.04). USACE San Joaquin O&M Manual 612.1, June 1965, (HLM 7.02), and 612 (addendum), February 1999, (HLM 6.97), (Station 368+08)]. FS Date: 2/18/2021

LS view: LS headwall at toe from crown.

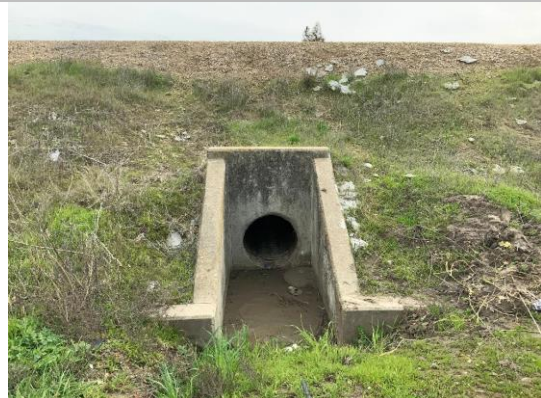
Photo 2 of 3 : UCIP_FA_2022_77274_91852.jpg

LS view: LS headwall at toe.
