**Flood Control Project Maintenance
Levee Inspections**

Maintenance Issue Types Only, Levee Inspection Report By Mile - Fall 2022

San Joaquin County Flood Control and Water Conservation District

Waterway	Bank	Unit Miles	Inspection Start/End	Inspector
Unit No. 01 Littlejohn Creek	Left	2.59	10/13/2022 10/13/2022	Alberto De Leon

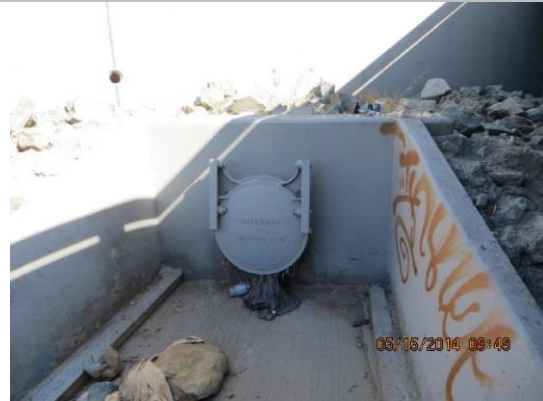
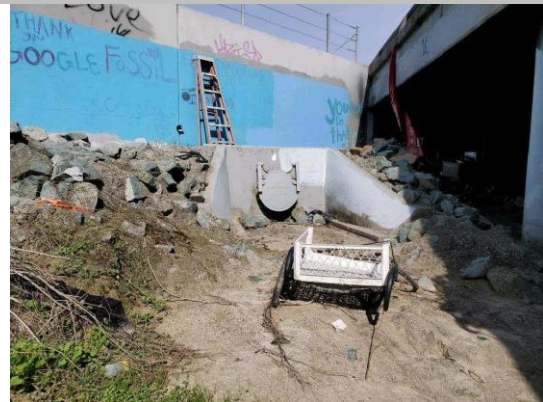
Photo 1 of 3 : UCIP_FA_2022_77276_68857.jpg

Comment Code					
Inspector Comment					
DS_ID:23559 FS_ID:77276 EP_NO: N/A Repair Type: Urgent EVAL Issue: 1, Pipe Integrity Crossing Status: Found UCIP Comments: 02/24/2021 The record has been upgraded from No Action Needed to Urgent. Did not inspect LS due to safety issues (large homeless encampment under freeway). DWR DMP has found integrity issues, LOF between 5 and 6. Crossing will be monitored until funding becomes available to address the issues. No permit was found authorizing this encroachment. CVFPB will need to review crossing to determine owner. The UCIP inspection was completed with GEI staff, B. Singh. (H. Dunn – GEI) FIELD_STRUCT_DESC: 24-inch corrugated metal storm drainage pipe (CMP) through the levee, 9.0 feet below the crown. Concrete U-shaped headwalls on both ends. Flap gate on the waterside (WS) end. Cobble grouted spillway across the berm. Cobble grouted apron on the landside (LS) end. [Additional Reference(s): DWR Levee Log, 1987, (HLM 7.17). USACE As-Built Drawing No. CA3-04-008, Sheet No. 28, 1 February 1963, existing structure just downstream of southbound Highway 99]. FS Date: 2/24/2021

Pipe, headwall, and flapgate on WS toe.

WS headwall and flapgate at toe.

WS flapgate at toe.

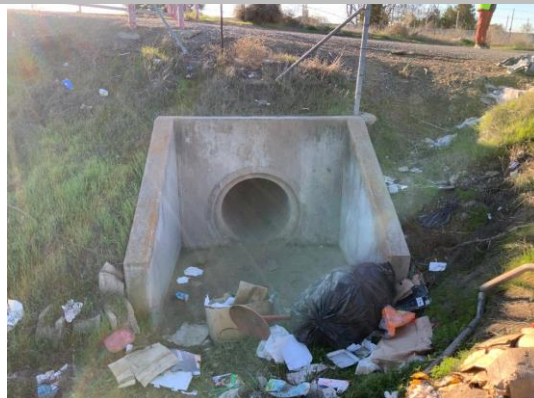
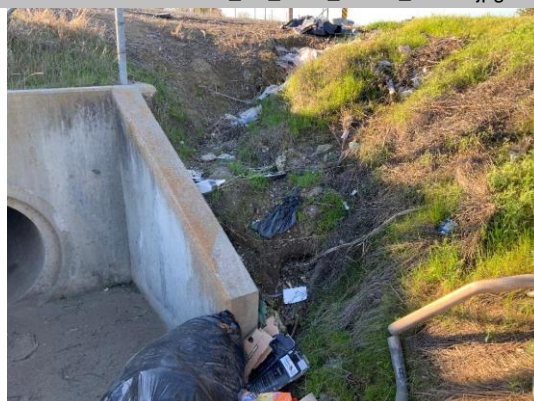
Photo 1 of 3 : UCIP_FA_2022_77278_91867.jpg

DS_ID:23561
FS_ID:77278
EP_NO: N/A
Repair Type: Non-Urgent
EVAL Issue: 6, Levee Damage or Threat for Levee Damage
Crossing Status: Found
UCIP Comments: 02/24/2021 The record has been upgraded from No Action Needed to Non-Urgent. Minor erosion along the right edge of the LS headwall and slope. DWR DMP has not found internal issues, LOF between 1 and 2. Recommend inspection in 5 years. No permit was found authorizing this encroachment. CVFPB will need to review crossing to determine owner. The UCIP inspection was completed with GEI staff, B. Singh. (H. Dunn – GEI)
FIELD_STRUCT_DESC: 36-inch concrete storm drainage pipe through the levee, 8.0 feet below the crown. Concrete U-shaped headwalls on both ends. Flap gate on the waterside (WS) end. Cobble grouted spillway across the berm. Cobble grouted apron on the landside (LS) end. [Additional Reference(s): DWR Levee Log, 1987, (HLM 7.21). USACE San Joaquin O&M Manual 612.2, 1967, (HLM 7.21)].

LS headwall at toe from crown.

LS headwall at toe.

LS headwall with minor erosion on slope on side of headwall.

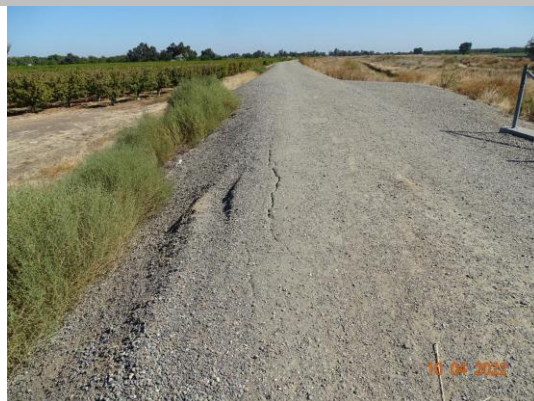
Photo 1 of 1 : FA_2022_NA0017_151_231_20221025_00578.jpg

View of soil separation along the landside shoulder. Fall 2022

LM Start	6.82	Rating **	M	Issue No.	231
LM End	6.82	Issue Type +	Ma	Location *	LS
Category	Earthen Levee			GPS Latitude/Longitude	
				Start	End
Item	Slope Stability			38.061691 °	38.061691 °
				-121.259037 °	-121.259037 °
DWR ID	DWR_NA0017_07_f_2022_231				
Comment Code					
S1 : Repair slope instability.					
Inspector Comment

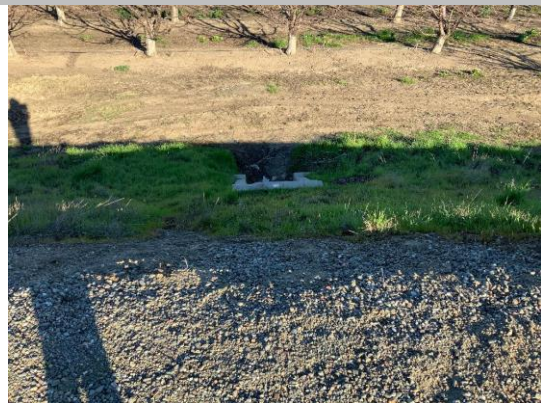
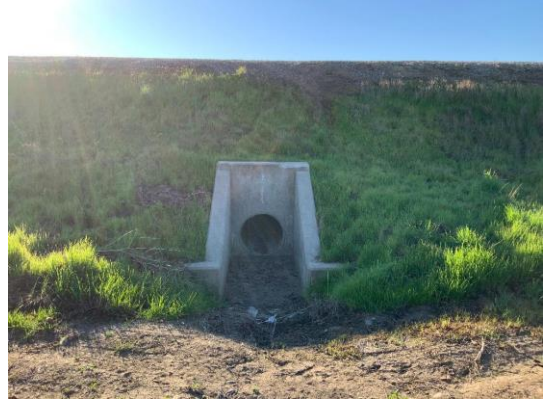
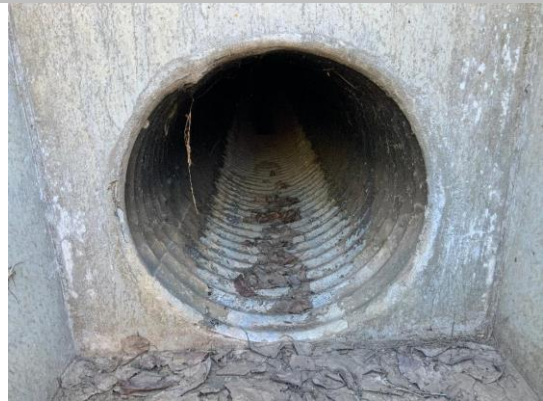
Photo 1 of 3 : UCIP_FA_2022_77280_91882.jpg

Comment Code						
Inspector Comment						
DS_ID:23562 FS_ID:77280 EP_NO: N/A Repair Type: Urgent EVAL Issue: 1, Pipe Integrity Crossing Status: Found UCIP Comments: 02/24/2021 Record updated from No Action Needed to Urgent. DMP internal video inspection has found pipe integrity issues. LOF of crossing is between 5 and 6. Crossing will be monitored until funding becomes available to address the issues. No permit was found authorizing this encroachment. CVFPB will need to review crossing to determine owner. The UCIP inspection was completed with GEI staff, B. Singh. (H. Dunn – GEI) FIELD_STRUCT_DESC: 24-inch corrugated metal storm drainage pipe (CMP) through the levee, 8.0 feet below the crown. Concrete U-shaped headwalls on both ends. Flap gate on the waterside (WS) end. Cobble grouted spillway across the berm. Cobble grouted apron on the landside (LS) end. [Additional Reference(s): DWR Levee Log, 1987, (HLM 7.34). USACE San Joaquin O&M Manual 612.2, 1967, (HLM 7.34), and 612 (addendum), February 1999, (HLM 7.30), (Station 385+65)]. FS Date: 2/24/2021

LS view: LS headwall at toe from crown.

LS view: LS headwall at toe.

LS view: LS pipe.

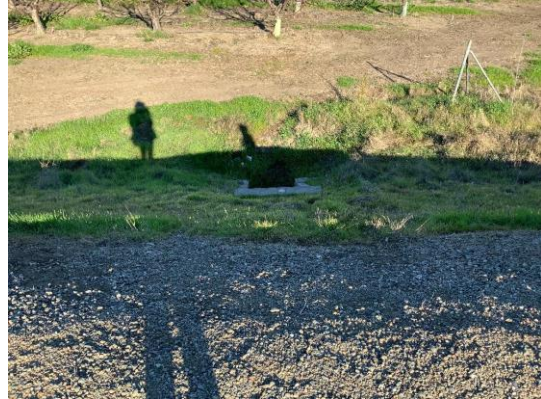
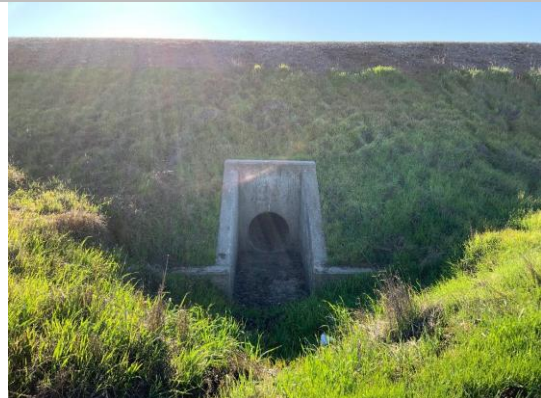
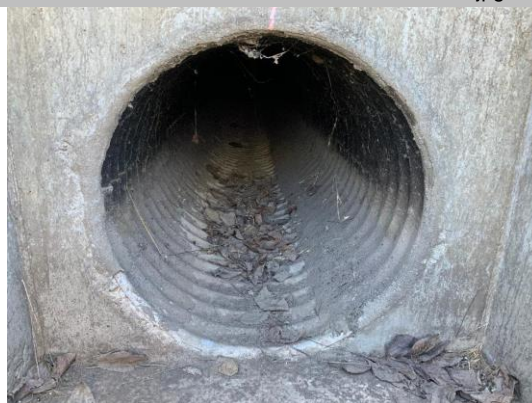
Photo 1 of 3 : UCIP_FA_2022_77281_91889.jpg

Comment Code						
Inspector Comment						
DS_ID:23563 FS_ID:77281 EP_NO: N/A Repair Type: Non-Urgent EVAL Issue: Crossing Status: Found UCIP Comments: 02/24/2021 The record has been upgraded from No Action Needed to Non-Urgent. DWR DMP has not found internal issues, LOF between 1 and 2. Recommend inspection in 5 years. No permit was found authorizing this encroachment. CVFPB will need to review crossing to determine owner. The UCIP inspection was completed with GEI staff, B. Singh. (H. Dunn – GEI) FIELD_STRUCT_DESC: 24-inch corrugated metal storm drainage pipe (CMP) through the levee, 7.0 feet below the crown. Concrete U-shaped headwalls on both ends. Flap gate on the waterside (WS) end. Cobble grouted spillway across the berm. Cobble grouted apron on the landside (LS) end. [Additional Reference(s): DWR Levee Log, 1987, (HLM 7.52). USACE San Joaquin O&M Manual 612.2, 1967, (HLM 7.51), and 612 (addendum), February 1999, (HLM 7.45), (Station 393+26)]. FS Date: 2/24/2021

LS headwall at toe from crown.

LS headwall at toe.

LS pipe.

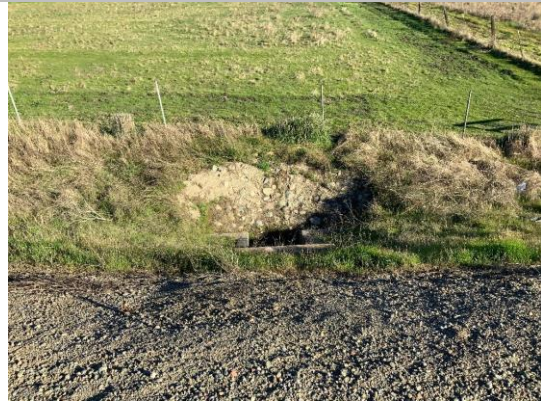
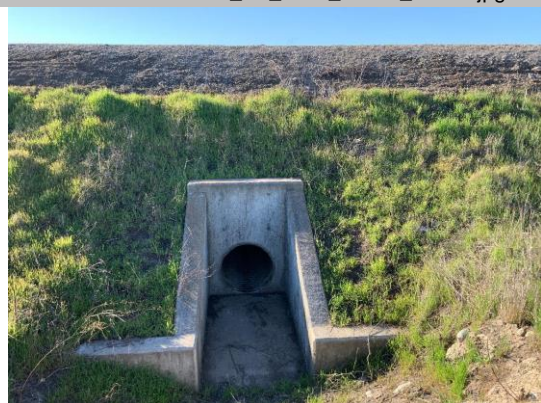
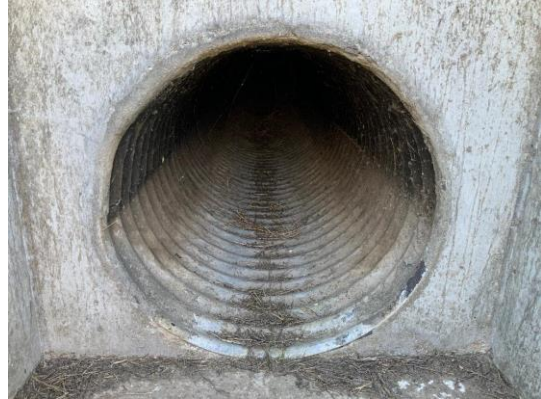
Photo 1 of 3 : UCIP_FA_2022_77282_91896.jpg

Comment Code						
Inspector Comment						
DS_ID:23564 FS_ID:77282 EP_NO: N/A Repair Type: Non-Urgent EVAL Issue: Crossing Status: Found UCIP Comments: 02/24/2021 The record has been upgraded from No Action Needed to Non-Urgent. DWR DMP has not found internal issues, LOF between 1 and 2. Recommend inspection in 5 years. No permit was found authorizing this encroachment. CVFPB will need to review crossing to determine owner. The UCIP inspection was completed with GEI staff, B. Singh. (H. Dunn – GEI) FIELD_STRUCT_DESC: 24-inch corrugated metal storm drainage pipe (CMP) through the levee, 7.5 feet below the crown. Concrete U-shaped headwalls on both ends. Flap gate on the waterside (WS) end. Cobble grouted spillway across the berm. Cobble grouted apron on the landside (LS) end. [Additional Reference(s): DWR Levee Log, 1987, (HLM 7.72). USACE San Joaquin O&M Manual 612.2, 1967, (HLM 7.72)]. FS Date: 2/24/2021

LS view: LS headwall at toe from crown.

LS view: LS headwall at toe.

LS view: LS pipe.

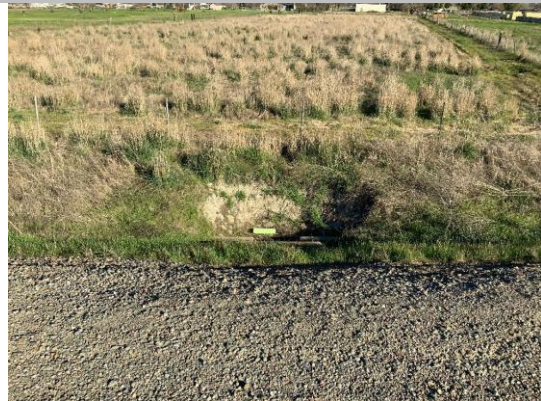
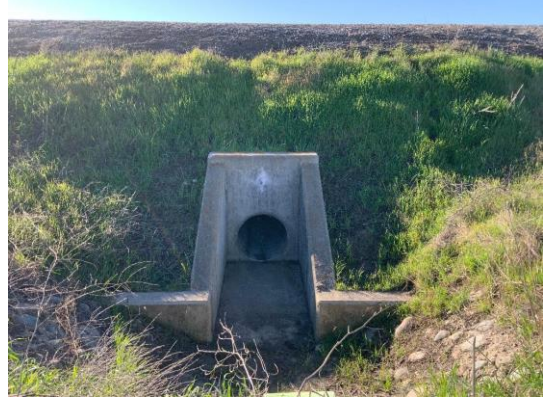
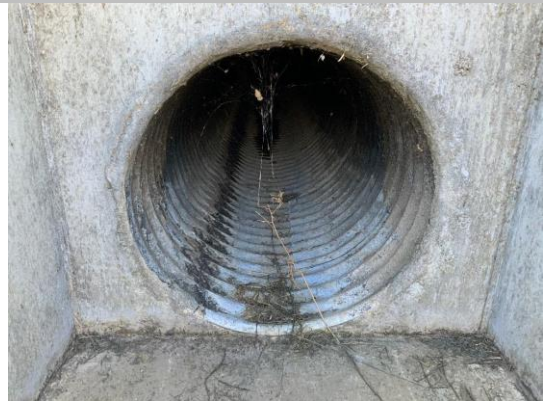
Photo 1 of 3 : UCIP_FA_2022_77283_91904.jpg

DS_ID:23565
 FS_ID:77283
 EP_NO: N/A
 Repair Type: Non-Urgent
 EVAL Issue: 5, Pipe Damage
 Crossing Status: Found
 UCIP Comments: 02/24/2021 The record has been upgraded from No Action Needed to Non-Urgent. DWR DMP has found integrity issues, LOF between 4 and 5. Crossing will be monitored until funding becomes available for rehabilitation. No permit was found authorizing this encroachment. CVFPB will need to review crossing to determine owner. The UCIP inspection was completed with GEI staff, B. Singh. (H. Dunn – GEI)
 FIELD_STRUCT_DESC: 24-inch corrugated metal storm drainage pipe (CMP) through the levee, 7.0 feet below the crown. Concrete U-shaped headwalls on both ends. Flap gate on the waterside (WS) end. Cobble grouted spillway across the berm. Cobble grouted apron on the landside (LS) end. [Additional Reference(s): DWR Levee Log, 1987, (HLM 7.75). USACE San Joaquin O&M Manual 612.2, 1967, (HLM 7.75)].

LS headwall at toe from crown.

LS headwall at toe.

LS pipe.

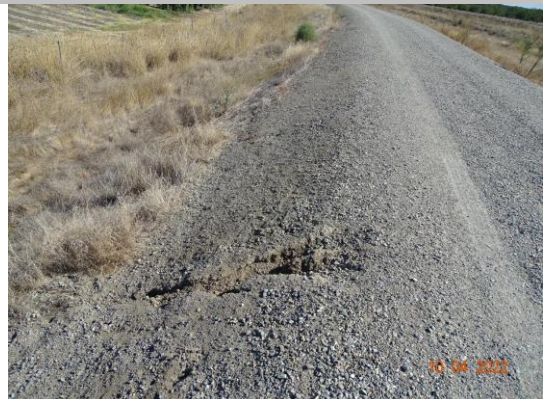
Photo 1 of 1 : FA_2022_NA0017_151_243_20221025_00579.jpg

View of erosion on the landside slope. Fall 2022

LM Start	7.35	Rating **	M	Issue No.	243
LM End	7.35	Issue Type +	Ma	Location *	LS
Category	Earthen Levee			GPS Latitude/Longitude	
				Start	End
Item	Erosion / Bank Caving			38.065080 °	38.065080 °
				-121.250546 °	-121.250546 °
DWR ID	DWR_NA0017_07_f_2022_243				
Comment Code					
E2 : Schedule repair of erosion site prior to the next inspection.					
Inspector Comment

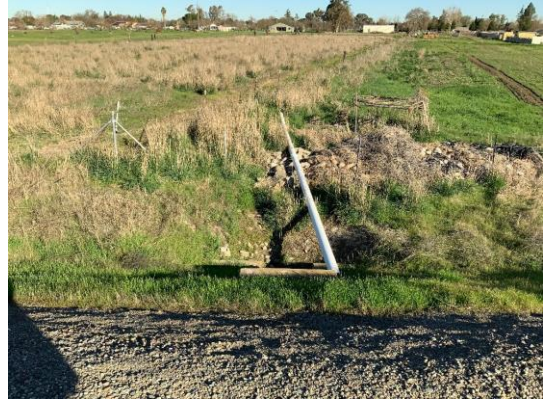
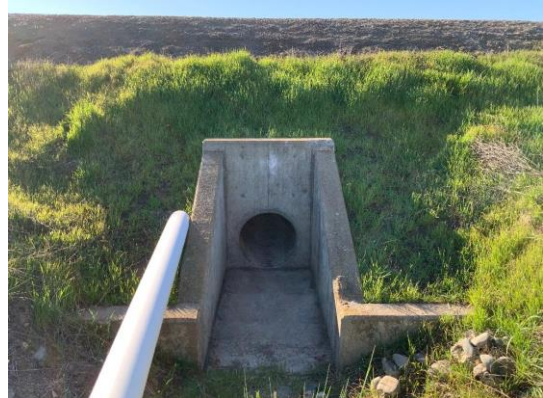
Photo 1 of 3 : UCIP_FA_2022_77284_91912.jpg

Comment Code					
Inspector Comment					
DS_ID:23566 FS_ID:77284 EP_NO: N/A Repair Type: Non-Urgent EVAL Issue: 5, Pipe Damage Crossing Status: Found UCIP Comments: 02/24/2021 The record has been upgraded from No Action Needed to Non-Urgent. DWR DMP has found integrity issues, LOF between 4 and 5. Crossing will be monitored until funding becomes available for rehabilitation. No permit was found authorizing this encroachment. CVFPB will need to review crossing to determine owner. Small plastic pipe that was previously laying inside drainage pipe is now laying outside adjacent to headwall. The UCIP inspection was completed with GEI staff, B. Singh. (H. Dunn – GEI) FIELD_STRUCT_DESC: 24-inch corrugated metal storm drainage pipe (CMP) through the levee, 7.0 feet below the crown. Concrete U-shaped headwalls on both ends. Flap gate on the waterside (WS) end. Cobble grouted spillway across the berm. Cobble grouted apron on the landside (LS) end. [Additional Reference(s): DWR Levee Log, 1987, (HLM 7.76). USACE San Joaquin O&M Manual 612.2, 1967, (HLM 7.76), and 612 (addendum), February 1999, (HLM 7.78), (Station 410+54)]. FS Date: 2/24/2021

LS headwall at toe from crown.

LS headwall at toe.

LS pipe.

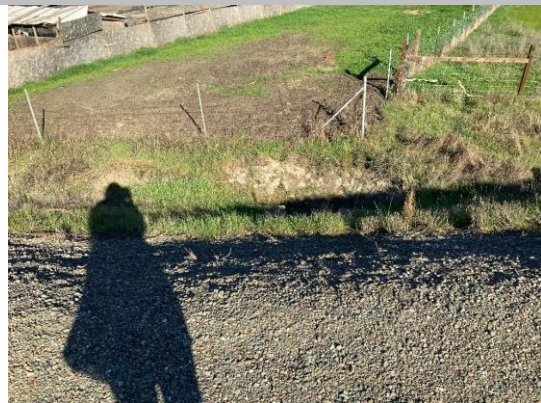
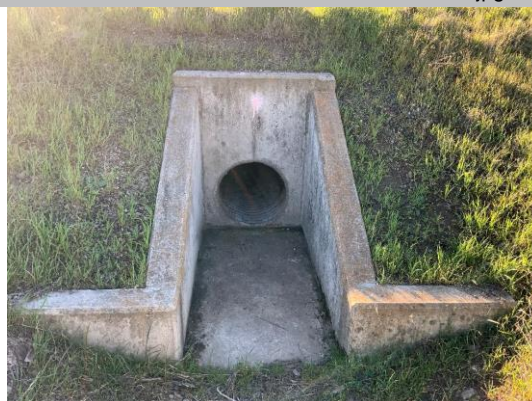
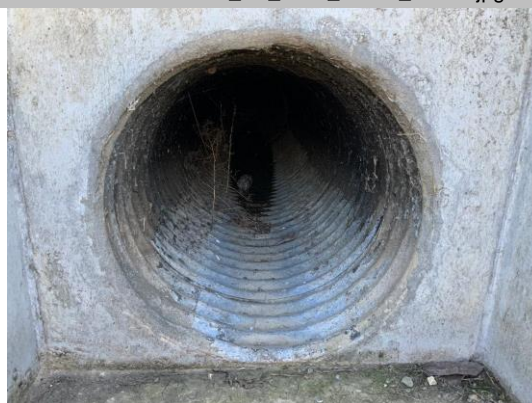
Photo 1 of 3 : UCIP_FA_2022_77285_91921.jpg

Comment Code						
Inspector Comment						
DS_ID:23567 FS_ID:77285 EP_NO: N/A Repair Type: Urgent EVAL Issue: 1, Pipe Integrity Crossing Status: Found UCIP Comments: 02/24/2021 The record has been upgraded from No Action Needed to Urgent. Significant peeling of metal inside LS pipe. DWR DMP has found integrity issues, LOF between 5 and 6. Crossing will be monitored until funding becomes available to address the issues. No permit was found authorizing this encroachment. CVFPB will need to review crossing to determine owner. The UCIP inspection was completed with GEI staff, B. Singh. (H. Dunn – GEI) FIELD_STRUCT_DESC: 24-inch corrugated metal storm drainage pipe (CMP) through the levee, 7.0 feet below the crown. Concrete U-shaped headwalls on both ends. Flap gate on the waterside (WS) end. Cobble grouted spillway across the berm. Cobble grouted apron on the landside (LS) end. [Additional Reference(s): DWR Levee Log, 1987, (HLM 7.99). USACE San Joaquin O&M Manual 612.2, 1967, (HLM 7.99), and 612 (addendum), February 1999, (HLM 7.94), (Station 419+06)]. FS Date: 2/24/2021

LS view: LS headwall at toe from crown.

LS view: LS headwall at toe.

LS view: LS pipe.

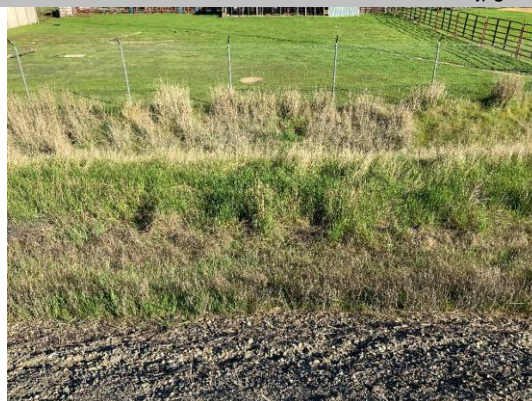
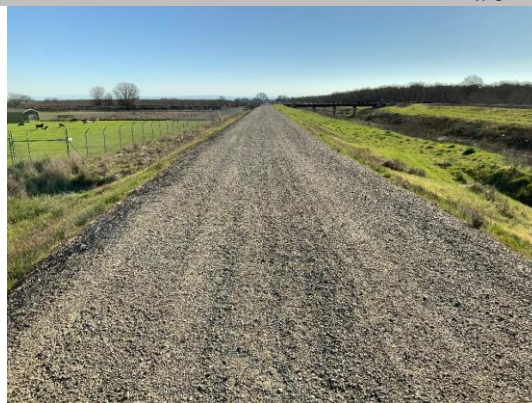
Photo 1 of 3 : UCIP_FA_2022_77286_91925.jpg

Comment Code						
Inspector Comment						
DS_ID:23663 FS_ID:77286 EP_NO: N/A Repair Type: Non-Urgent EVAL Issue: Crossing Status: Not Found UCIP Comments: 02/24/2021 The record has been upgraded from No Action Needed to Non-Urgent. Pipe not found by visual inspection. DWR DMP geophysical study did not confirm presence of pipe through levee. Record will remain in UCIP's inspection records until future Levee Improvement Project can confirm no crossing was found through the levee. No permit was found authorizing this encroachment. CVFPB will need to review crossing to determine owner. The UCIP inspection was completed with GEI staff, B. Singh. (H. Dunn – GEI) FIELD_STRUCT_DESC: 24-inch storm drainage pipe of an unknown material through the levee, at an unknown depth. [Additional Reference(s): USACE San Joaquin O&M Manual 612 (addendum), February 1999, (HLM 8.14), (Station 429+90)]. FS Date: 2/24/2021

LS view: LS toe from crown, no pipe visible.

Levee crown looking upstream.

WS view: WS toe from crown, no pipe visible.

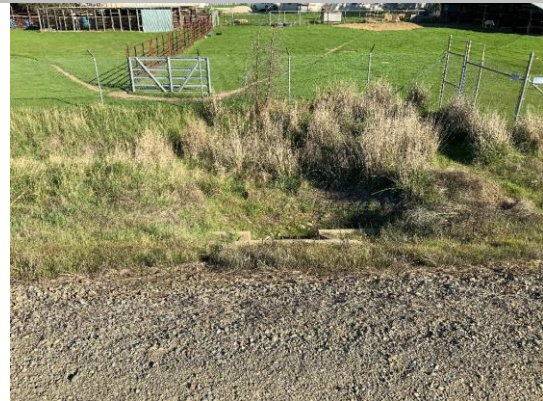
Photo 1 of 3 : UCIP_FA_2022_77287_91930.jpg

DS_ID:23568
 FS_ID:77287
 EP_NO: N/A
 Repair Type: Non-Urgent
 EVAL Issue: 5, Pipe Damage
 Crossing Status: Found
 UCIP Comments: 02/24/2021 The record has been upgraded from No Action Needed to Non-Urgent. Significant peeling of metal inside LS pipe. DWR DMP has found integrity issues, LOF between 4 and 5. Crossing will be monitored until funding becomes available for rehabilitation. No permit was found authorizing this encroachment. CVFPB will need to review crossing to determine owner. The UCIP inspection was completed with GEI staff, B. Singh. (H. Dunn – GEI)
 FIELD_STRUCT_DESC: 36-inch corrugated metal storm drainage pipe (CMP) through the levee, 8.0 feet below the crown. Concrete U-shaped headwalls on both ends. Flap gate on the waterside (WS) end. Cobble grouted spillway across the berm. Cobble grouted apron on the landside (LS) end. [Additional Reference(s): DWR Levee Log, 1987, (HLM 8.15). USACE San Joaquin O&M Manual 612.2, 1967, (HLM 8.15)].

LS view: LS headwall at toe from crown.

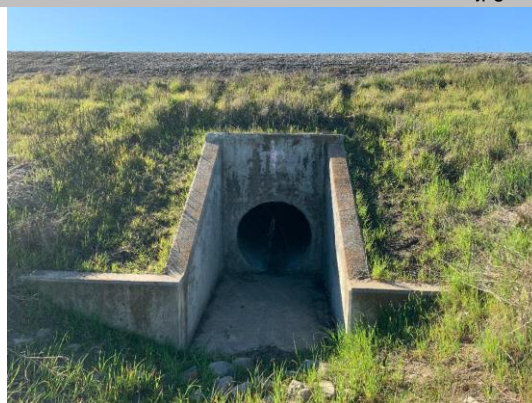
Photo 2 of 3 : UCIP_FA_2022_77287_91931.jpg

LS view: LS headwall at toe.

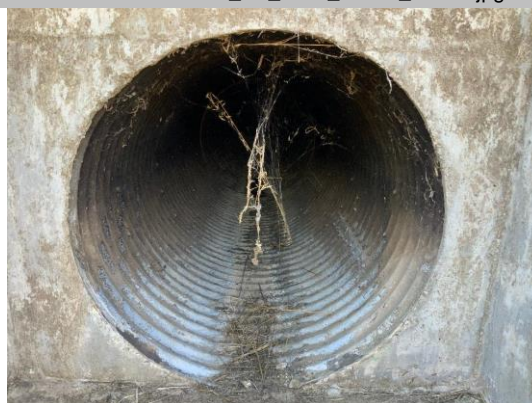
Photo 3 of 3 : UCIP_FA_2022_77287_91932.jpg

LS view: LS pipe.

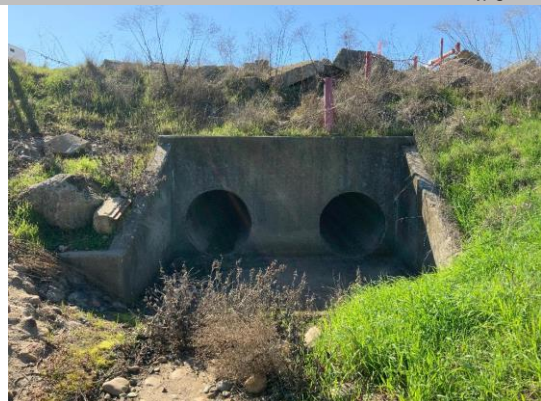
Photo 2 of 3 : UCIP_FA_2022_77316_91943.jpg

LS view: LS headwall at toe.

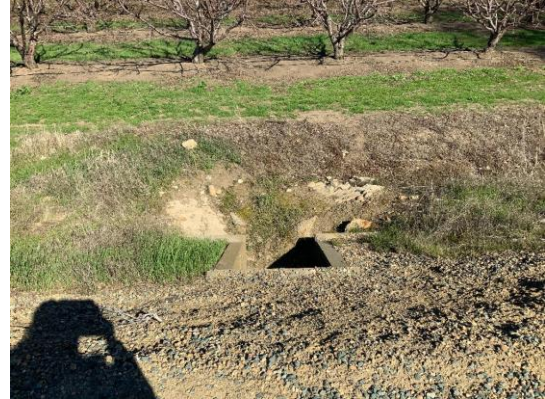
Photo 1 of 3 : UCIP_FA_2022_77292_91962.jpg

Comment Code						
Inspector Comment						
DS_ID:23570 FS_ID:77292 EP_NO: N/A Repair Type: Non-Urgent EVAL Issue: 5, Pipe Damage Crossing Status: Found UCIP Comments: 02/24/2021 The record has been upgraded from No Action Needed to Non-Urgent. DWR DMP has found integrity issues, LOF between 4 and 5. Crossing will be monitored until funding becomes available for rehabilitation. No permit was found authorizing this encroachment. CVFPB will need to review crossing to determine owner. The UCIP inspection was completed with GEI staff, B. Singh. (H. Dunn – GEI) FIELD_STRUCT_DESC: 24-inch corrugated metal storm drainage pipe (CMP) through the levee, 6.5 feet below the crown. Flap gate on the waterside (WS) end. Concrete U-shaped headwalls on both ends. Cobble grouted spillway across the berm. Cobble grouted apron on the landside (LS) end. [Additional Reference(s): DWR Levee Log, 1987, (HLM 8.49). USACE San Joaquin O&M Manual 612.2, 1967, (HLM 8.49), and 612 (addendum), February 1999, (HLM 8.41), (Station 444+00)]. FS Date: 2/24/2021

LS headwall at toe from crown.

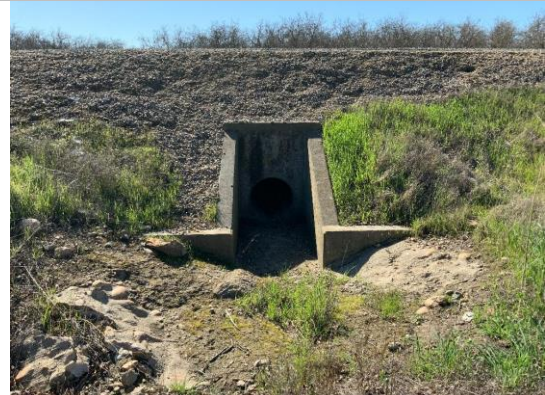
Photo 2 of 3 : UCIP_FA_2022_77292_91963.jpg

LS headwall at toe.

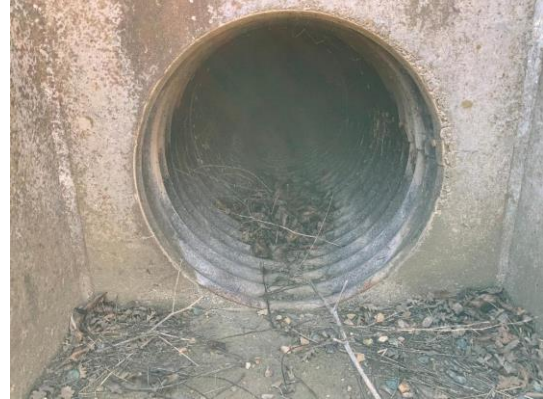
Photo 3 of 3 : UCIP_FA_2022_77292_91964.jpg

LS pipe.

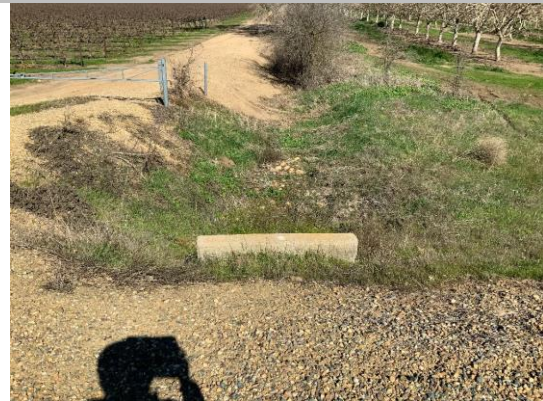
Photo 1 of 3 : UCIP_FA_2022_77296_91987.jpg

DS_ID:23572
 FS_ID:77296
 EP_NO: N/A
 Repair Type: Urgent
 EVAL Issue: 1, Pipe Integrity
 Crossing Status: Found
 UCIP Comments: 02/24/2021 The record has been upgraded from Non-Urgent to Urgent. Significant peeling of metal and gap inside of LS pipe. DWR DMP has found integrity issues, LOF between 5 and 6. Crossing will be monitored until funding becomes available to address the issues. No permit was found authorizing this encroachment. CVFPB will need to review crossing to determine owner. The UCIP inspection was completed with GEI staff, B. Singh. (H. Dunn – GEI) 05/14/2014 A gap at the joint between pipe sections was noted inside pipe at LS toe. This may indicate a need for further maintenance. (W. Wylie -DWR UCIP)
 FIELD_STRUCT_DESC: 36-inch corrugated metal storm drainage pipe (CMP) through the levee, 7.0 feet below the crown. Flap gate on the waterside (WS) end. Concrete U-shaped headwalls on both ends. Cobble grouted spillway across the berm. Cobble grouted apron on the landside (LS) end. [Additional Reference(s): DWR Levee Log, 1987, (HLM 8.77). USACE San Joaquin O&M Manual 612.2, 1967, (HLM 8.77)].

LS view: LS headwall at toe from crown.

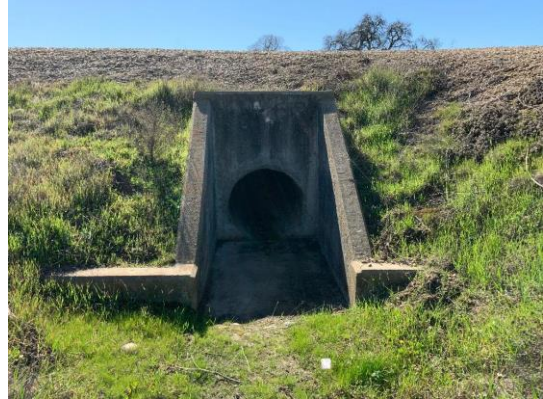
Photo 2 of 3 : UCIP_FA_2022_77296_91988.jpg

LS view: LS headwall at toe.

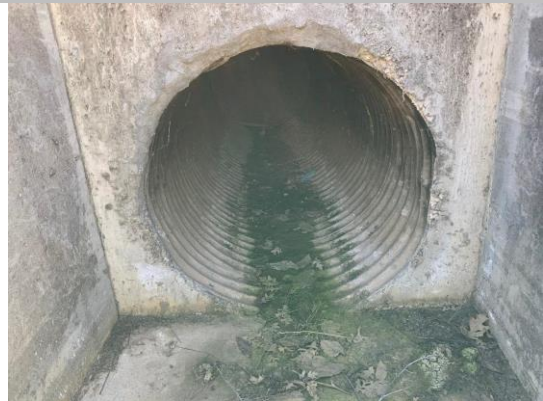
Photo 3 of 3 : UCIP_FA_2022_77296_91989.jpg

LS view: LS pipe.

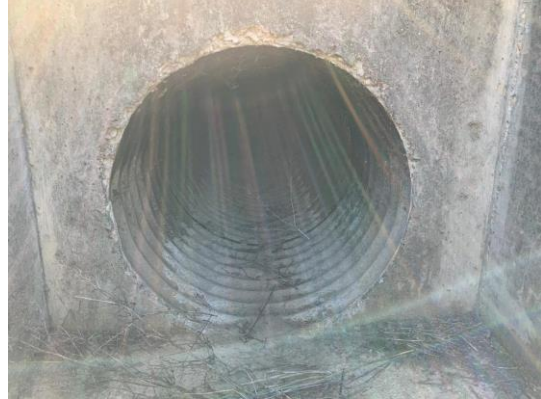
Photo 3 of 3 : UCIP_FA_2022_77297_91998.jpg

LS view: LS pipe.

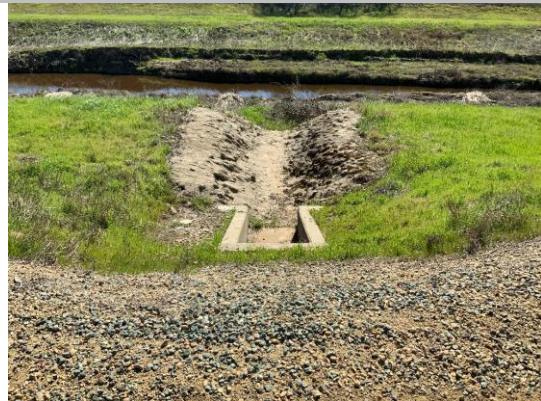
Photo 1 of 3 : UCIP_FA_2022_77298_92004.jpg

DS_ID:23574
 FS_ID:77298
 EP_NO: N/A
 Repair Type: Non-Urgent
 EVAL Issue: 5, Pipe Damage
 Crossing Status: Found
 UCIP Comments: 02/24/2021 The record has been upgraded from No Action Needed to Non-Urgent. DWR DMP has found integrity issues, LOF between 4 and 5. Crossing will be monitored until funding becomes available for rehabilitation. No permit was found authorizing this encroachment. CVFPB will need to review crossing to determine owner. The UCIP inspection was completed with GEI staff, B. Singh. (H. Dunn – GEI)
 FIELD_STRUCT_DESC: 24-inch corrugated metal storm drainage pipe (CMP) through the levee, 7.0 feet below the crown. Flap gate on the waterside (WS) end. Concrete U-shaped headwalls on both ends. Cobble grouted spillway across the berm. [Additional Reference(s): DWR Levee Log, 1987, (HLM 8.97). USACE San Joaquin O&M Manual 612.2, 1967, (HLM 8.97), and 612 (addendum), February 1999, (HLM 8.90), (Station 469+82)].

WS view: WS headwall at toe.

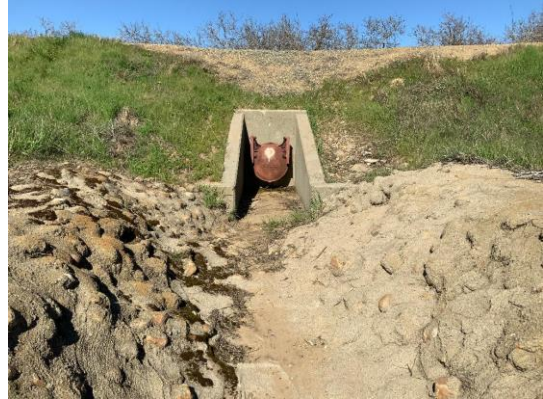
Photo 2 of 3 : UCIP_FA_2022_77298_92005.jpg

WS view: WS headwall and flapgate at toe.

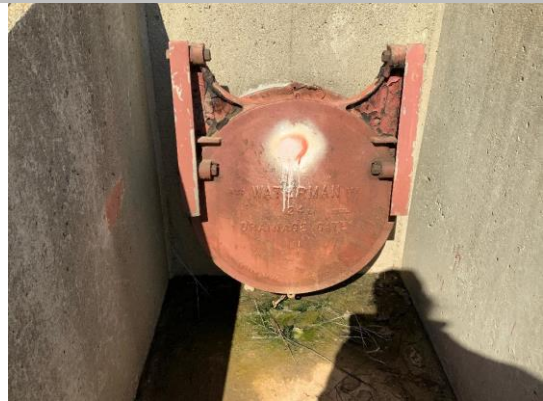
Photo 3 of 3 : UCIP_FA_2022_77298_92006.jpg

WS view: WS flapgate.

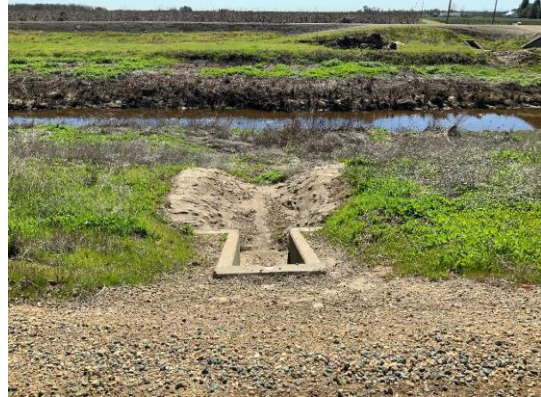
Photo 1 of 3 : UCIP_FA_2022_77318_92009.jpg

Comment Code						
Inspector Comment						
DS_ID:23576 FS_ID:77318 EP_NO: N/A Repair Type: Non-Urgent EVAL Issue: 5, Pipe Damage Crossing Status: Found UCIP Comments: 02/24/2021 The record has been upgraded from No Action Needed to Non-Urgent. DWR DMP has found integrity issues, LOF between 4 and 5. Crossing will be monitored until funding becomes available for rehabilitation. Minor flaking off of concrete on the inside edge of LS headwall. No permit was found authorizing this encroachment. CVFPB will need to review crossing to determine owner. The UCIP inspection was completed with GEI staff, B. Singh. (H. Dunn – GEI) FIELD_STRUCT_DESC: 24-inch corrugated metal storm drainage pipe (CMP) through the levee, 6.5 feet below the crown. Flap gate on the waterside (WS) end. Concrete U-shaped headwalls on both ends. Cobble grouted spillway across the berm. Cobble grouted apron on the landside (LS) end. [Additional Reference(s): DWR Levee Log, 1987, (HLM 9.18). USACE San Joaquin O&M Manual 612.2, 1967, (HLM 9.17), and 612 (addendum), February 1999, (HLM 9.17), (Station 484+30)]. FS Date: 2/24/2021

WS view: WS headwall at toe from crown.

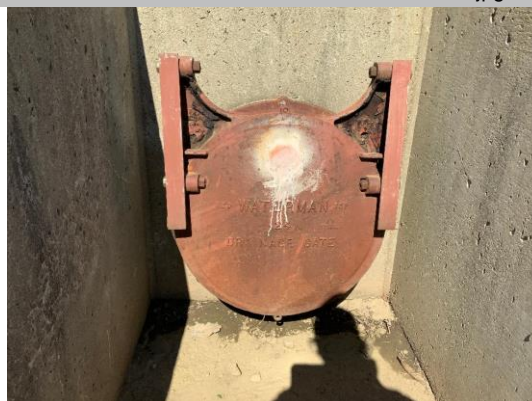
Photo 3 of 3 : UCIP_FA_2022_77318_92012.jpg

WS view: WS flapgate.

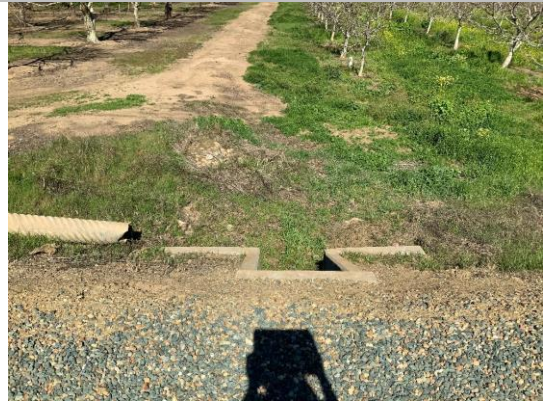
Photo 1 of 3 : UCIP_FA_2022_77302_92030.jpg

Comment Code						
Inspector Comment						
DS_ID:23578 FS_ID:77302 EP_NO: N/A Repair Type: Non-Urgent EVAL Issue: Crossing Status: Found UCIP Comments: 02/24/2021 The record has been upgraded from No Action Needed to Non-Urgent. DWR DMP has not found internal issues, LOF between 1 and 2. Recommend inspection in 5 years. No permit was found authorizing this encroachment. CVFPB will need to review crossing to determine owner. The UCIP inspection was completed with GEI staff, B. Singh. (H. Dunn – GEI) FIELD_STRUCT_DESC: 24-inch corrugated metal storm drainage pipe (CMP) through the levee, 8.0 feet below the crown. Flap gate on the waterside (WS) end. Concrete U-shaped headwalls on both ends. Cobble grouted spillway across the berm. Cobble grouted apron on the landside (LS) end. [Additional Reference(s): DWR Levee Log, 1987, (HLM 9.41). USACE San Joaquin O&M Manual 612.2, 1967, (HLM 9.41), and 612 (addendum), February 1999, (HLM 9.37), (Station 494+50)]. FS Date: 2/24/2021

LS view: LS headwall at toe from crown.

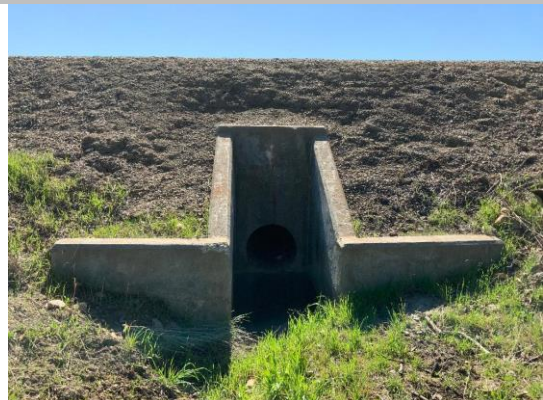
Photo 2 of 3 : UCIP_FA_2022_77302_92029.jpg

LS view: LS headwall at toe.

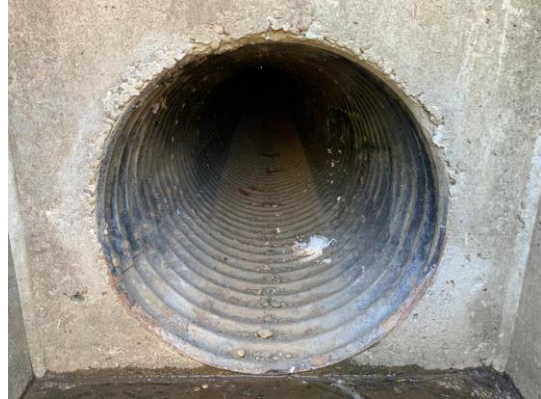
Photo 3 of 3 : UCIP_FA_2022_77302_92028.jpg

LS view: LS pipe.

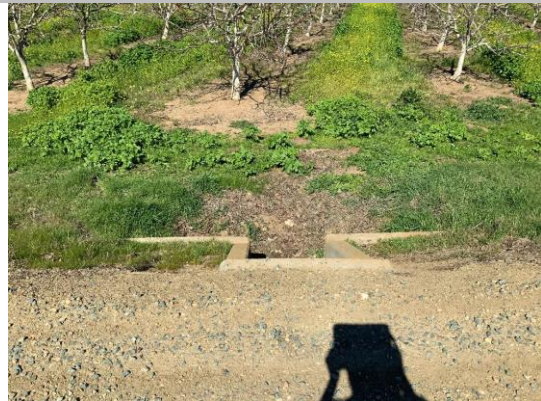
Photo 1 of 3 : UCIP_FA_2022_77304_92040.jpg

DS_ID:23580
 FS_ID:77304
 EP_NO: N/A
 Repair Type: Non-Urgent
 EVAL Issue: 5, Pipe Damage
 Crossing Status: Found
 UCIP Comments: 02/24/2021 The record has been upgraded from No Action Needed to Non-Urgent. DWR DMP has found integrity issues, LOF between 4 and 5. Crossing will be monitored until funding becomes available for rehabilitation. No permit was found authorizing this encroachment. CVFPB will need to review crossing to determine owner. The UCIP inspection was completed with GEI staff, B. Singh. (H. Dunn – GEI)
 FIELD_STRUCT_DESC: 24-inch corrugated metal storm drainage pipe (CMP) through the levee, 6.5 feet below the crown. Flap gate on the waterside (WS) end. Concrete U-shaped headwalls on both ends. Cobble grouted spillway and apron. [Additional Reference(s): DWR Levee Log, 1987, (HLM 9.56). USACE San Joaquin O&M Manual 612.2, 1967, (HLM 9.56), and 612 (addendum), February 1999, (HLM 9.56), (Station 504+71)].

LS headwall at toe from crown.

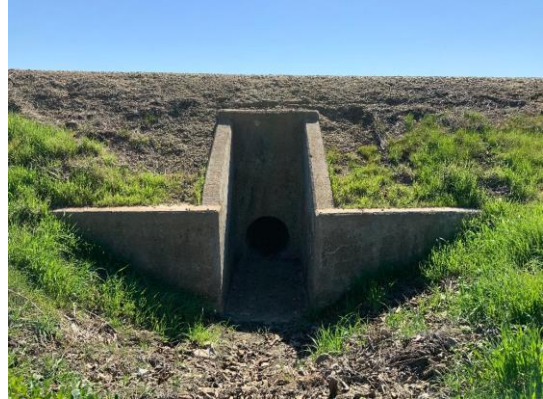
Photo 2 of 3 : UCIP_FA_2022_77304_92041.jpg

LS headwall at toe.

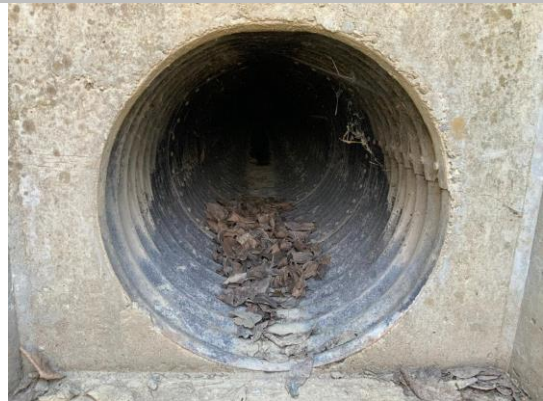
Photo 3 of 3 : UCIP_FA_2022_77304_92042.jpg

LS pipe.

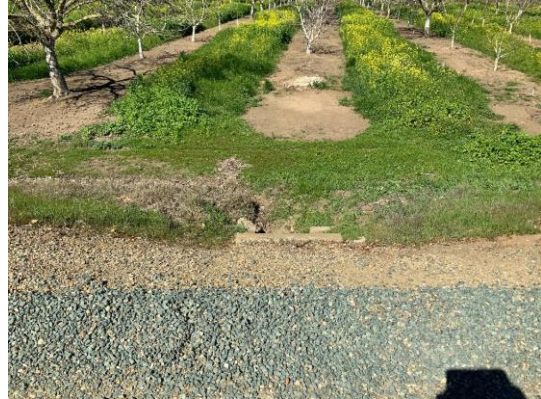
Photo 1 of 3 : UCIP_FA_2022_77307_92058.jpg

Comment Code						
Inspector Comment						
DS_ID:23582 FS_ID:77307 EP_NO: N/A Repair Type: Non-Urgent EVAL Issue: 5, Pipe Damage Crossing Status: Found UCIP Comments: 02/24/2021 The record has been upgraded from No Action Needed to Non-Urgent. DWR DMP has found integrity issues, LOF between 4 and 5. Crossing will be monitored until funding becomes available for rehabilitation. No permit was found authorizing this encroachment. CVFPB will need to review crossing to determine owner. The UCIP inspection was completed with GEI staff, B. Singh. (H. Dunn – GEI) FIELD_STRUCT_DESC: 24-inch corrugated metal storm drainage pipe (CMP) through the levee, 7.5 feet below the crown. Flap gate on the waterside (WS) end. Concrete U-shaped headwalls on both ends. Cobble grouted spillway across the berm. Cobble grouted apron on the WS end. [Additional Reference(s): DWR Levee Log, 1987, (HLM 9.91). USACE San Joaquin O&M Manual 612.2, 1967, (HLM 9.91)]. FS Date: 2/24/2021

LS view: LS headwall at toe from crown.

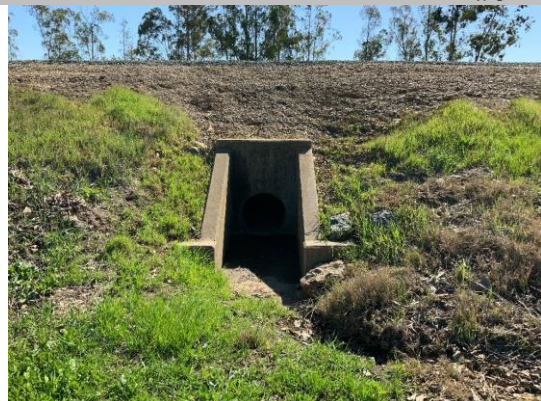
Photo 2 of 3 : UCIP_FA_2022_77307_92059.jpg

LS view: LS headwall at toe.

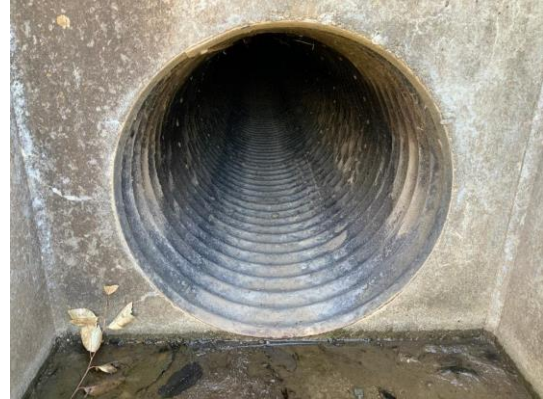
Photo 3 of 3 : UCIP_FA_2022_77307_92060.jpg

LS view: LS pipe.

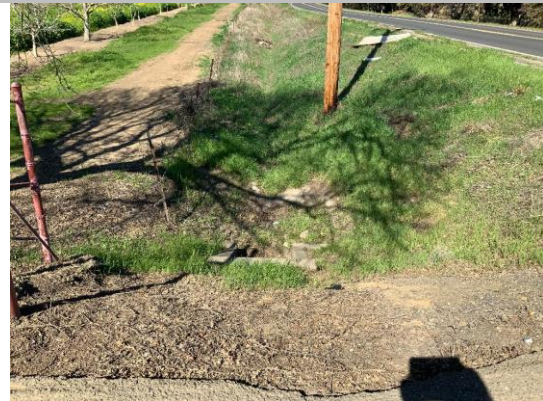
Photo 1 of 3 : UCIP_FA_2022_77308_92065.jpg

DS_ID:23583
 FS_ID:77308
 EP_NO: N/A
 Repair Type: Non-Urgent
 EVAL Issue: 5, Pipe Damage
 Crossing Status: Found
 UCIP Comments: 02/24/2021 The record has been upgraded from No Action Needed to Non-Urgent. DWR DMP has found integrity issues, LOF between 4 and 5. Crossing will be monitored until funding becomes available for rehabilitation. No permit was found authorizing this encroachment. CVFPB will need to review crossing to determine owner. The UCIP inspection was completed with GEI staff, B. Singh. (H. Dunn – GEI)
 FIELD_STRUCT_DESC: 24-inch corrugated metal storm drainage pipe (CMP) through the levee, 10.0 feet below the crown. Flap gate on the waterside (WS) end. Concrete U-shaped headwalls on both ends. Cobble grouted spillway across the berm. Cobble grouted apron on the landside (LS) end. [Additional Reference(s): DWR Levee Log, 1987, (HLM 10.09). USACE San Joaquin O&M Manual 612.2, 1967, (HLM 10.09), and 612 (addendum), February 1999, (HLM 9.94), (Station 524+90)].

LS view: LS headwall at toe from crown.

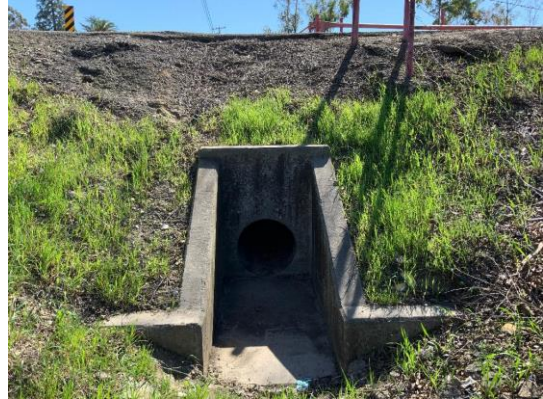
Photo 2 of 3 : UCIP_FA_2022_77308_92066.jpg

LS view: LS headwall at toe.

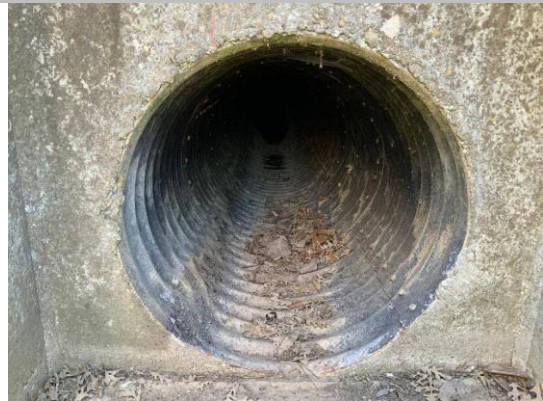
Photo 3 of 3 : UCIP_FA_2022_77308_92067.jpg

LS view: LS pipe.

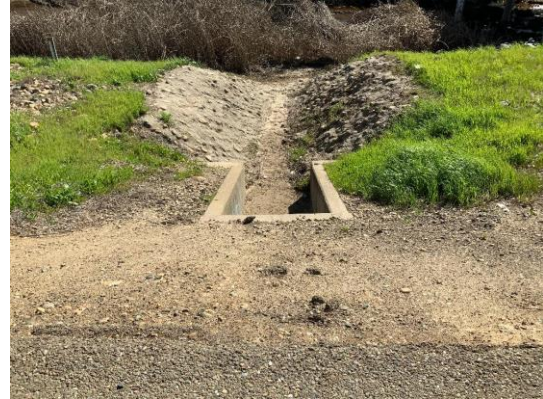
Photo 1 of 3 : UCIP_FA_2022_77310_92077.jpg

Comment Code						
Inspector Comment						
DS_ID:23584 FS_ID:77310 EP_NO: N/A Repair Type: Non-Urgent EVAL Issue: 5, Pipe Damage Crossing Status: Found UCIP Comments: 02/24/2021 The record has been upgraded from No Action Needed to Non-Urgent. DWR DMP has found integrity issues, LOF between 4 and 5. Crossing will be monitored until funding becomes available for rehabilitation. No permit was found authorizing this encroachment. CVFPB will need to review crossing to determine owner. The UCIP inspection was completed with GEI staff, B. Singh. (H. Dunn – GEI) FIELD_STRUCT_DESC: 36-inch corrugated metal storm drainage pipe (CMP) through the levee, 6.0 feet below the crown. Flap gate on the waterside (WS) end. Concrete U-shaped headwalls on both ends. Cobble grouted spillway across the berm. Cobble grouted apron on the landside (LS) end. [Additional Reference(s): DWR Levee Log, 1987, (HLM 10.11). USACE San Joaquin O&M Manual 612.2, 1967, (HLM 10.11)]. FS Date: 2/24/2021

WS view: WS headwall at toe from crown.

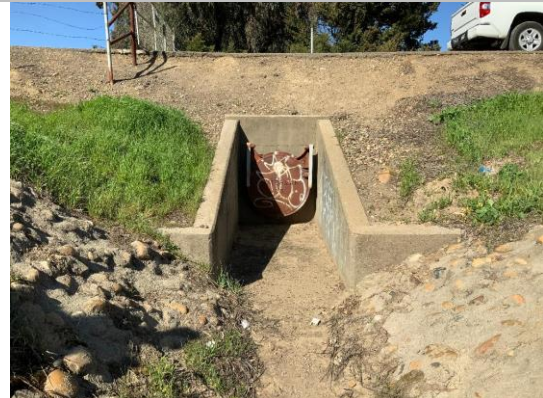
Photo 2 of 3 : UCIP_FA_2022_77310_92078.jpg

WS view: WS headwall and flapgate at toe.

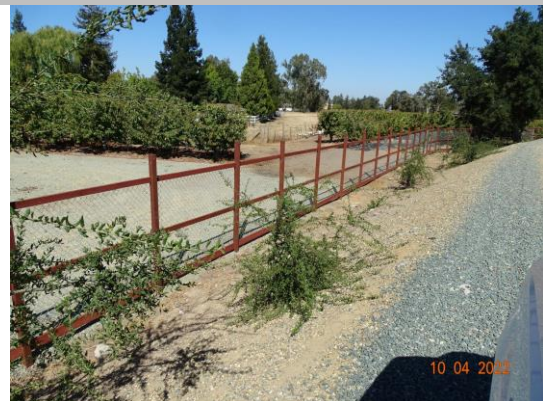
Photo 1 of 1 : FA_2022_NA0017_151_273_20221025_00584.jpg

LM Start	9.93	Rating **	M	Issue No.	273
LM End	10.02	Issue Type +	Ma	Location *	LS
Category	Earthen Levee		GPS Latitude/Longitude		
			Start	End	
Item	Vegetation		38.076668 °	38.077671 °	
			-121.208584 °	-121.207646 °	
DWR ID	DWR_NA0017_07_f_2022_273				
Comment Code					
V2 : Remove the wild growth and woody vegetation other than native grasses from the levee slopes.					
Inspector Comment					
New trees planted along the landside slope.

View of newly planted trees along the landside slope. Fall 2022

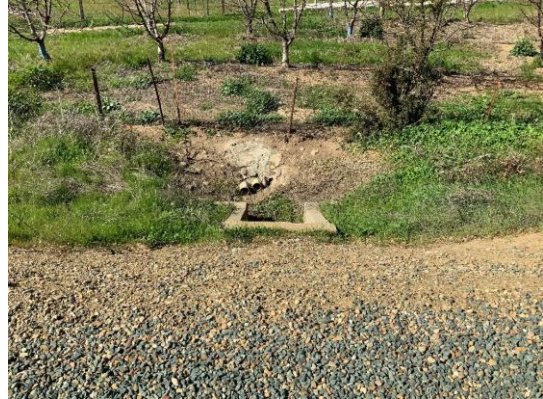
Photo 1 of 3 : UCIP_FA_2022_77312_92096.jpg

Comment Code						
Inspector Comment						
DS_ID:23585 FS_ID:77312 EP_NO: N/A Repair Type: Non-Urgent EVAL Issue: Crossing Status: Found UCIP Comments: 02/24/2021 Pipe status is still Non-Urgent. DWR DMP has not found internal issues, LOF between 1 and 2. Recommend inspection in 5 years. No permit was found authorizing this encroachment. CVFPB will need to review crossing to determine owner. The UCIP inspection was completed with GEI staff, B. Singh. (H. Dunn – GEI) FIELD_STRUCT_DESC: 24-inch corrugated metal storm drainage pipe (CMP) through the levee, 7.5 feet below the crown. Flap gate on the waterside (WS) end. Concrete U-shaped headwalls on both ends. Cobble grouted spillway across the berm. [Additional Reference(s): DWR Levee Log, 1987, (HLM 10.45). USACE San Joaquin O&M Manual 612.2, 1967, (HLM 10.45), and 612 (addendum), February 1999, (HLM 10.46), (Station 552+25)]. FS Date: 2/24/2021

LS view: LS headwall at toe from crown.

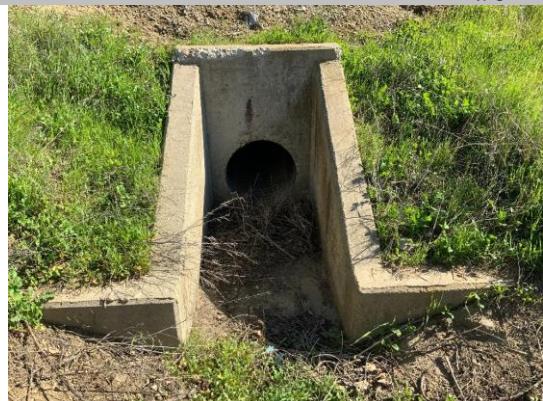
Photo 2 of 3 : UCIP_FA_2022_77312_92097.jpg

LS view: LS headwall at toe.

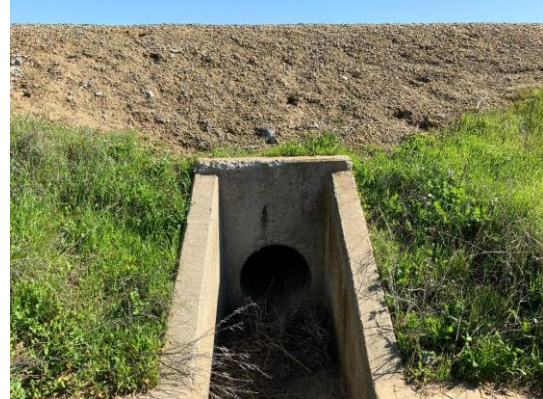
Photo 3 of 3 : UCIP_FA_2022_77312_92098.jpg

LS view: LS headwall at toe.

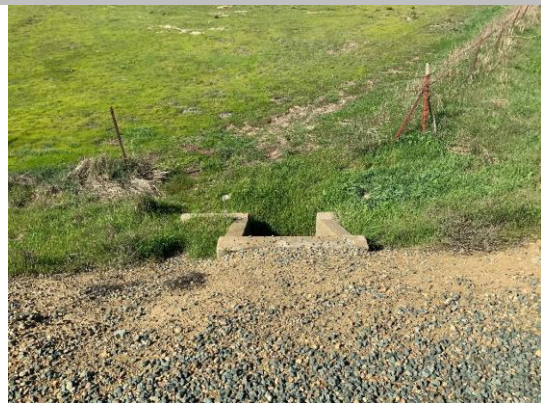
Photo 1 of 3 : UCIP_FA_2022_77314_92108.jpg

Comment Code						
Inspector Comment						
DS_ID:23586 FS_ID:77314 EP_NO: N/A Repair Type: Non-Urgent EVAL Issue: Crossing Status: Found UCIP Comments: 02/24/2021 The record has been upgraded from No Action Needed to Non-Urgent. DWR DMP has not found internal issues, LOF between 1 and 2. Recommend inspection in 5 years. No permit was found authorizing this encroachment. CVFPB will need to review crossing to determine owner. The UCIP inspection was completed with GEI staff, B. Singh. (H. Dunn – GEI) FIELD_STRUCT_DESC: 24-inch corrugated metal storm drainage pipe (CMP) through the levee, 6.0 feet below the crown. Flap gate on the waterside (WS) end. Concrete U-shaped headwalls on both ends. Cobble grouted spillway across the berm. Cobble grouted apron on the landside (LS) end. [Additional Reference(s): USACE San Joaquin O&M Manual 612.2, 1967, (HLM 10.62)]. FS Date: 2/24/2021

LS view: LS headwall at toe from crown.

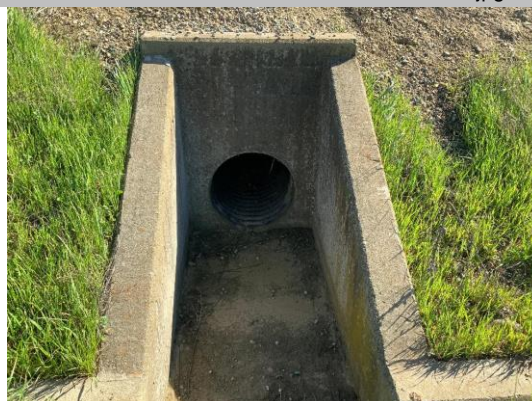
Photo 2 of 3 : UCIP_FA_2022_77314_92109.jpg

LS view: LS headwall at toe.

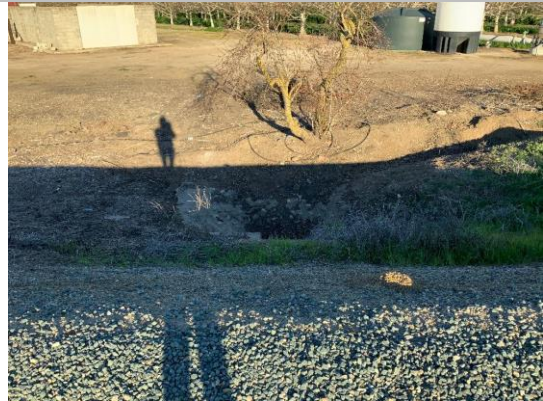
Photo 1 of 3 : UCIP_FA_2022_77319_92115.jpg

Comment Code					
Inspector Comment					
DS_ID:23646 FS_ID:77319 EP_NO: N/A Repair Type: Non-Urgent EVAL Issue: Crossing Status: Found UCIP Comments: 02/25/2021 The record has been upgraded from No Action Needed to Non-Urgent. DWR DMP has not found internal issues, LOF between 1 and 2. Recommend inspection in 5 years. WS flapgate partially covered by vegetation. No permit was found authorizing this encroachment. CVFPB will need to review crossing to determine owner. The UCIP inspection was completed with LMA representative, M. Mccoy. (H. Dunn – GEI) FIELD_STRUCT_DESC: 24-inch corrugated metal storm drainage pipe (CMP) through the levee, 7.5 feet below the crown. Flap gate on the waterside (WS) end. Concrete U-shaped headwalls on both ends. [Additional Reference(s): DWR Levee Log, 1987, (HLM 10.62). USACE San Joaquin O&M Manual 612.2, 1967, (HLM 10.91), and 612 (addendum), February 1999, (HLM 10.80), (Station 570+48)]. FS Date: 2/25/2021

LS view: LS headwall at toe from crown.

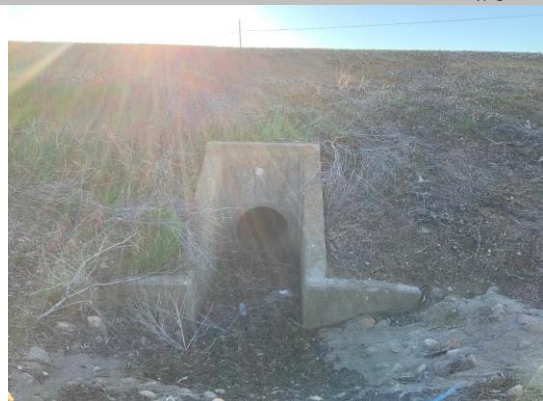
Photo 2 of 3 : UCIP_FA_2022_77319_92116.jpg

LS view: LS headwall at toe.

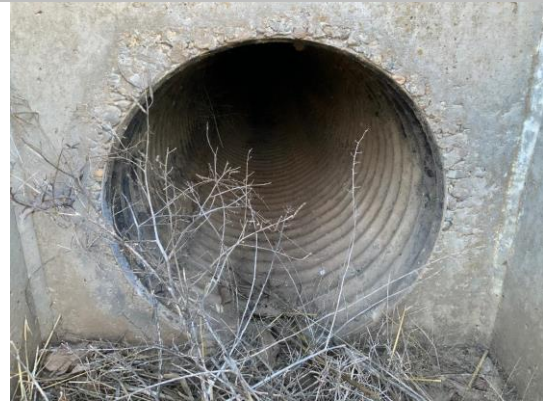
Photo 3 of 3 : UCIP_FA_2022_77319_92117.jpg

LS view: LS pipe.

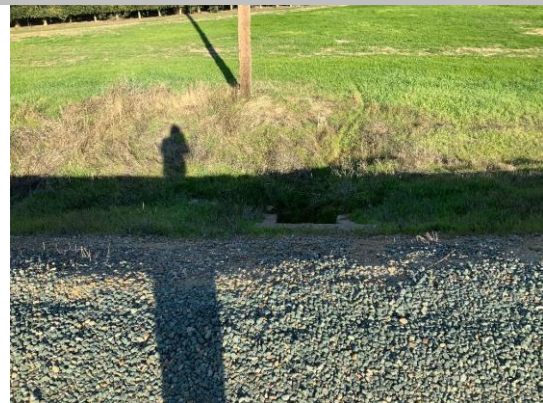
Photo 1 of 3 : UCIP_FA_2022_77320_92127.jpg

DS_ID:23587
 FS_ID:77320
 EP_NO: N/A
 Repair Type: Non-Urgent
 EVAL Issue:
 Crossing Status: Found
 UCIP Comments: 02/25/2021 Pipe status is still Non-Urgent. DWR DMP has not found internal issues, LOF between 1 and 2. Recommend inspection in 5 years. No permit was found authorizing this encroachment. CVFPB will need to review crossing to determine owner. The UCIP inspection was completed with LMA representative, M. McCoy. (H. Dunn – GEI) 05/14/2014 Silt buildup in pipe at LS toe. (W. Wylie - DWR UCIP)
 FIELD_STRUCT_DESC: 24-inch corrugated metal storm drainage pipe (CMP) through the levee, 6.5 feet below the crown. Flap gate on the waterside (WS) end. Concrete U-shaped headwalls on both ends. Cobble grouted spillway across the berm. Cobble grouted apron on the WS end. [Additional Reference(s): DWR Levee Log, 1987, (HLM 11.14). USACE San Joaquin O&M Manual 612.2, 1967, (HLM 11.13)].
 FS Date: 2/25/2021

LS view: LS headwall at toe from crown.

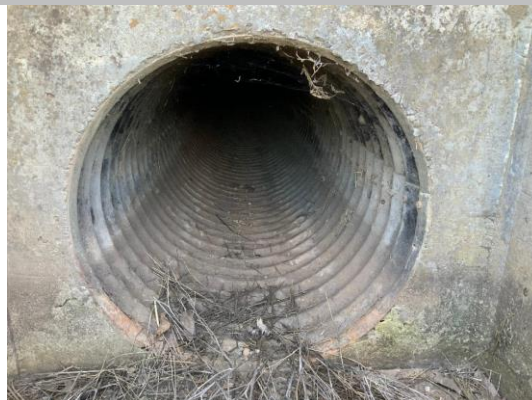
Photo 3 of 3 : UCIP_FA_2022_77320_92129.jpg

LS view: LS pipe.
