**Flood Control Project Maintenance
Levee Inspections**

Maintenance Issue Types Only, Levee Inspection Report By Mile - Fall 2022

San Joaquin County Flood Control and Water Conservation District

Waterway	Bank	Unit Miles	Inspection Start/End	Inspector
Unit No. 01 Littlejohn Creek	Left	2.59	10/13/2022 10/13/2022	Alberto De Leon

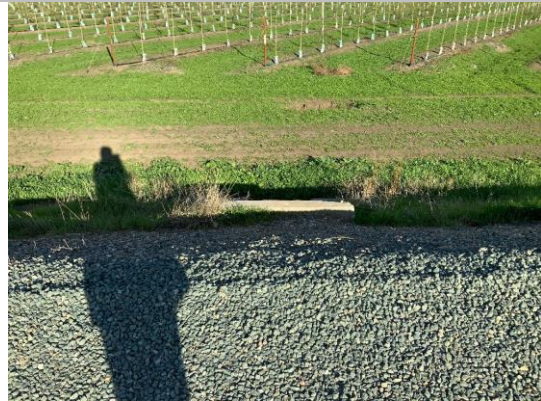
Photo 1 of 3 : UCIP_FA_2022_77321_92134.jpg

Comment Code						
Inspector Comment						
DS_ID:23588 FS_ID:77321 EP_NO: N/A Repair Type: Non-Urgent EVAL Issue: Crossing Status: Found UCIP Comments: 02/25/2021 The record has been upgraded from No Action Needed to Non-Urgent. DWR DMP has not found internal issues, LOF between 1 and 2. Recommend inspection in 5 years. No permit was found authorizing this encroachment. CVFPB will need to review crossing to determine owner. The UCIP inspection was completed with LMA representative, M. McCoy. (H. Dunn – GEI) FIELD_STRUCT_DESC: 24-inch corrugated metal storm drainage pipe (CMP) through the levee, 6.5 feet below the crown. Flap gate on the waterside (WS) end. Concrete U-shaped headwalls on both ends. Cobble grouted spillway across the berm. Cobble grouted apron on the landside (LS) end. [Additional Reference(s): DWR Levee Log, 1987, (HLM 11.30). USACE San Joaquin O&M Manual 612.2, 1967, (HLM 11.30), and 612 (addendum), February 1999, (HLM 11.26), (Station 594+46)]. FS Date: 2/25/2021

LS headwall at toe from crown.

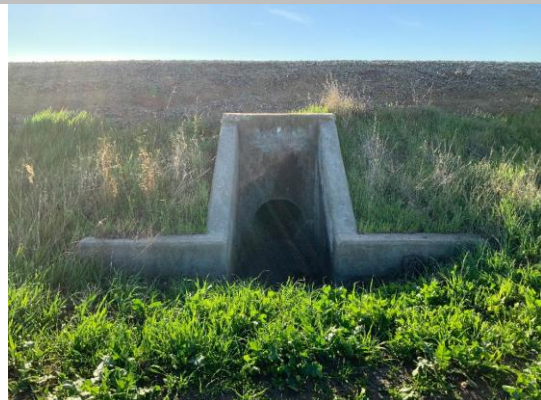
Photo 2 of 3 : UCIP_FA_2022_77321_92135.jpg

LS headwall at toe.

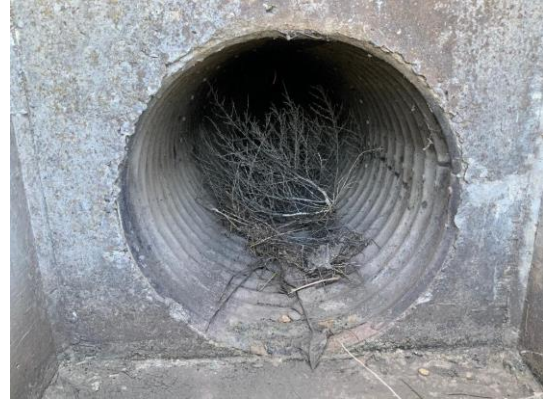
Photo 3 of 3 : UCIP_FA_2022_77321_92136.jpg

LS pipe, minor vegetation inside pipe.

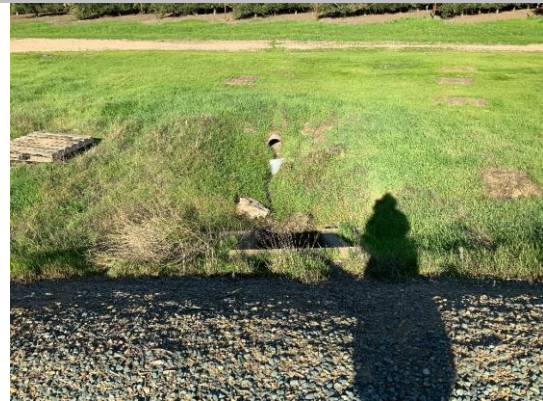
Photo 1 of 3 : UCIP_FA_2022_77325_92218.jpg

DS_ID:23590
 FS_ID:77325
 EP_NO: N/A
 Repair Type: Non-Urgent
 EVAL Issue:
 Crossing Status: Found
 UCIP Comments: 02/25/2021 The record has been upgraded from No Action Needed to Non-Urgent. DWR DMP has not found internal issues, LOF between 1 and 2. Recommend inspection in 5 years. No permit was found authorizing this encroachment. CVFPB will need to review crossing to determine owner. The UCIP inspection was completed with LMA representative, M. McCoy. (H. Dunn – GEI)
 FIELD_STRUCT_DESC: 24-inch corrugated metal storm drainage pipe (CMP) through the levee, 7.5 feet below the crown. Flap gate on the waterside (WS) end. Concrete U-shaped headwalls on both ends. Cobble grouted spillway across the berm. Cobble grouted apron on the landside (LS) end. [Additional Reference(s): DWR Levee Log, 1987, (HLM 11.78). USACE San Joaquin O&M Manual 612.2, 1967, (HLM 11.78)].
 FS Date: 2/25/2021

LS view: LS headwall at toe from crown.

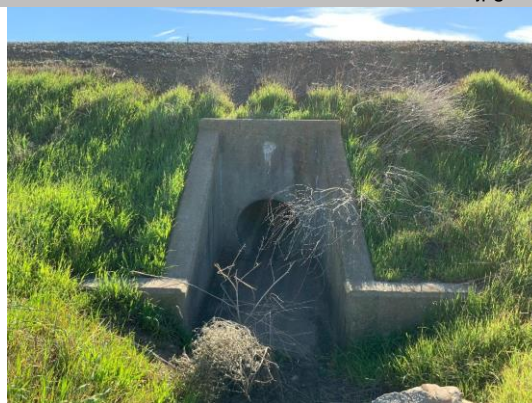
Photo 2 of 3 : UCIP_FA_2022_77325_92219.jpg

LS view: LS headwall at toe.

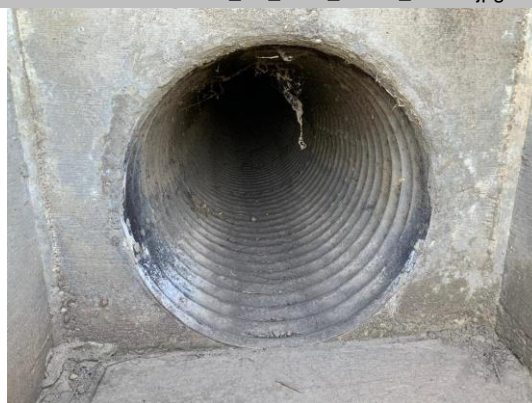
Photo 3 of 3 : UCIP_FA_2022_77325_92220.jpg

LS view: LS pipe.

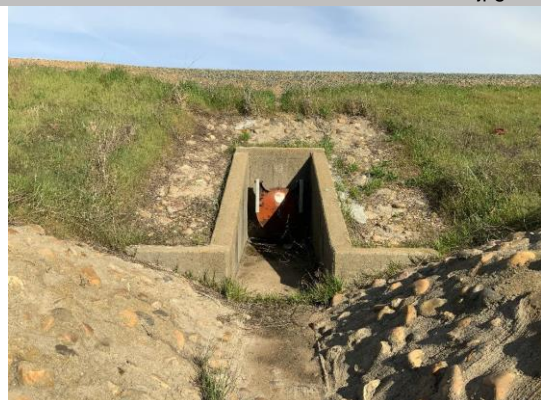
Photo 2 of 3 : UCIP_FA_2022_77329_92240.jpg

WS headwall and flapgate at toe.

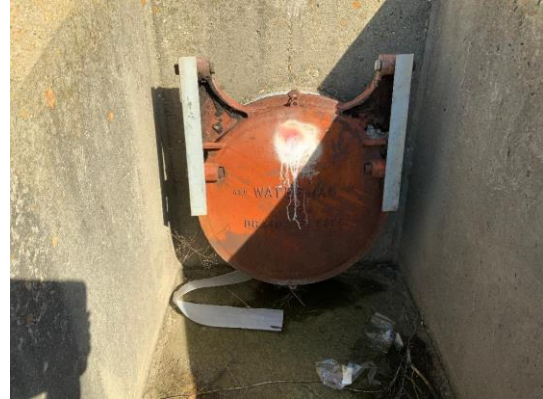
Photo 3 of 3 : UCIP_FA_2022_77329_92241.jpg

WS flapgate.

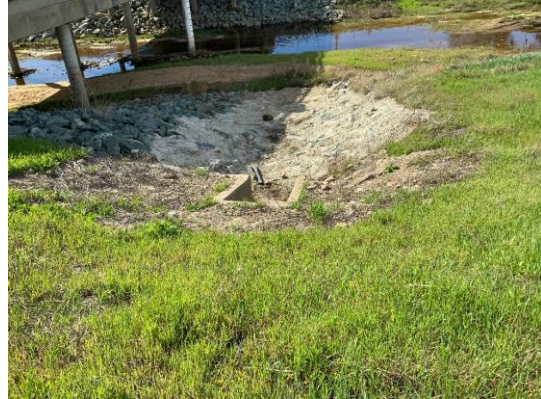
Photo 1 of 3 : UCIP_FA_2022_77330_92247.jpg

Comment Code						
Inspector Comment						
DS_ID:23594 FS_ID:77330 EP_NO: N/A Repair Type: Non-Urgent EVAL Issue: 10, Unauthorized Modification or Non-Compliant Permit Crossing Status: Found UCIP Comments: 02/25/2021 The record has been upgraded from No Action Needed to Non-Urgent. In August 2018, under the DWR DMP efforts the internal inspection found integrity issues, LOF between 5 and 6. According to Mr. Eric Ambriz, with San Joaquin County, Caltrans completed the slip Snap-Tite lining effort in October 2018. There is currently no post install inspection of the Snap-Tite lining. Unable to locate permit for sleeving PVC pipe. No permit was found authorizing original 24-inch CMP. CVFPB will need to review crossing to determine owner. The UCIP inspection was completed with LMA representative, M. McCoy. (H. Dunn – GEI) 10/10/2018 20-inch Snap-Tite lining pipes were sleeved through the damaged 24-inch CMP culvert. Annular space was pressure grouted. (A. McDonald - DWR UCIP) FIELD_STRUCT_DESC: 24-inch corrugated metal storm drainage pipe (CMP) sleeved with a 20-inch Snap-Tite culvert lining pipe through the levee, 7.5 feet below the crown. Annular space pressure grouted. Flap gate on the waterside (WS) end. Concrete U-shaped headwalls on each end. Cobble grouted spillway across the berm. Cobble grouted apron on the landside (LS) end. [Additional Reference(s): DWR Levee Log, 1987, (HLM 12.40). USACE San Joaquin O&M Manual 612.2, 1967, (HLM 12.40)]. FS Date: 2/25/2021

WS view: WS headwall at toe from crown.

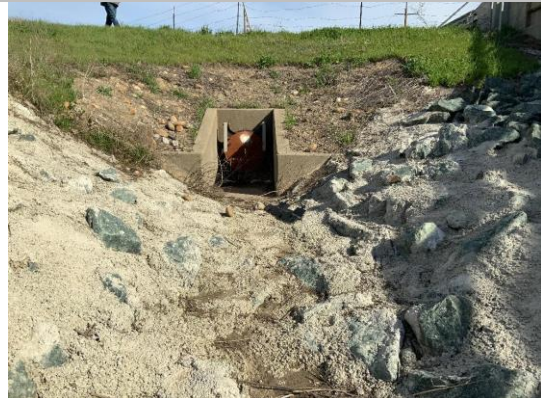
Photo 2 of 3 : UCIP_FA_2022_77330_92248.jpg

WS view: WS headwall and flapgate at toe.

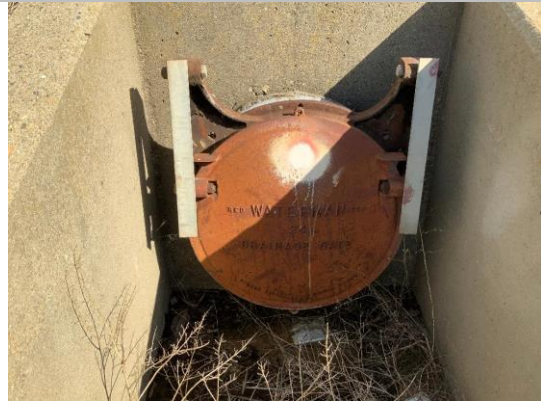
Photo 3 of 3 : UCIP_FA_2022_77330_92249.jpg

WS view: WS flapgate.

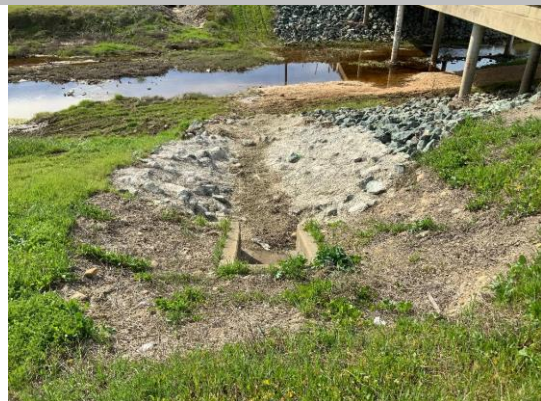
Photo 1 of 3 : UCIP_FA_2022_77331_92256.jpg

DS_ID:23505
 FS_ID:77331
 EP_NO: N/A
 Repair Type: Non-Urgent
 EVAL Issue:
 Crossing Status: Found
 UCIP Comments: 02/25/2021 The record has been upgraded from No Action Needed to Non-Urgent. Edges of LS pipe are warped. DWR DMP has not found internal issues, LOF between 1 and 2. Recommend inspection in 5 years. No permit was found authorizing this encroachment. CVFPB will need to review crossing to determine owner. The UCIP inspection was completed with LMA representative, M. McCoy. (H. Dunn – GEI)
 FIELD_STRUCT_DESC: 24-inch corrugated metal storm drainage pipe (CMP) through the levee, 7.5 feet below the crown. Flap gate on the waterside (WS) end. Concrete U-shaped headwalls on both ends. Cobble grouted spillway across the berm. Cobble grouted apron on the landside (LS) end. [Additional Reference(s): DWR Levee Log, 1987, (HLM 12.42). USACE San Joaquin O&M Manual 612.2, 1967, (HLM 12.42)].
 FS Date: 2/25/2021

WS view: WS headwall at toe from crown.

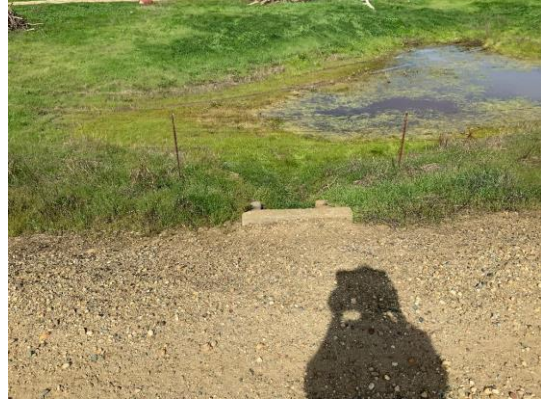
Photo 1 of 3 : UCIP_FA_2022_77333_92274.jpg

Comment Code						
Inspector Comment						
DS_ID:23507 FS_ID:77333 EP_NO: N/A Repair Type: Non-Urgent EVAL Issue: Crossing Status: Found UCIP Comments: 02/25/2021 The record has been upgraded from No Action Needed to Non-Urgent. DWR DMP has not found internal issues, LOF between 1 and 2. Recommend inspection in 5 years. No permit was found authorizing this encroachment. CVFPB will need to review crossing to determine owner. The UCIP inspection was completed with LMA representative, M. McCoy. (H. Dunn – GEI) FIELD_STRUCT_DESC: 24-inch corrugated metal storm drainage pipe (CMP) through the levee, 7.5 feet below the crown. Flap gate on the waterside (WS) end. Concrete U-shaped headwalls on both ends. Cobble grouted spillway across the berm. Cobble grouted apron on the landside (LS) end. [Additional Reference(s): DWR Levee Log, 1987, (HLM 12.64). USACE San Joaquin O&M Manual 612.2, 1967, (HLM 12.64), and 612 (addendum), February 1999, (HLM 12.61), (Station 666+02)]. FS Date: 2/25/2021

LS view: LS headwall at toe from crown.

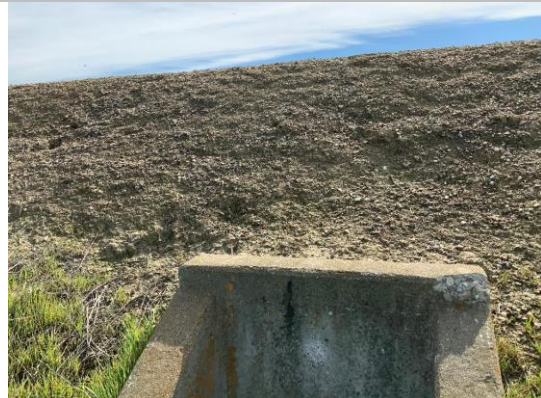
Photo 2 of 3 : UCIP_FA_2022_77333_92276.jpg

LS view: LS headwall at toe.

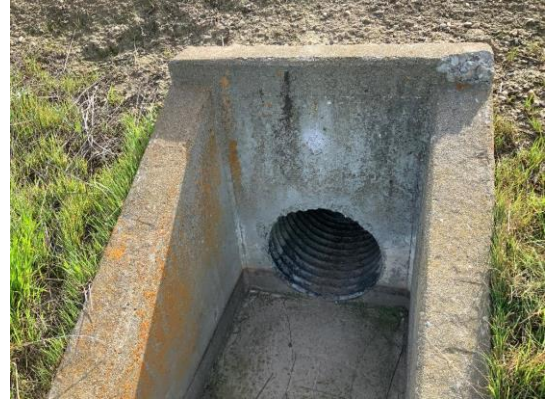
Photo 3 of 3 : UCIP_FA_2022_77333_92275.jpg

LS view: LS headwall at toe.

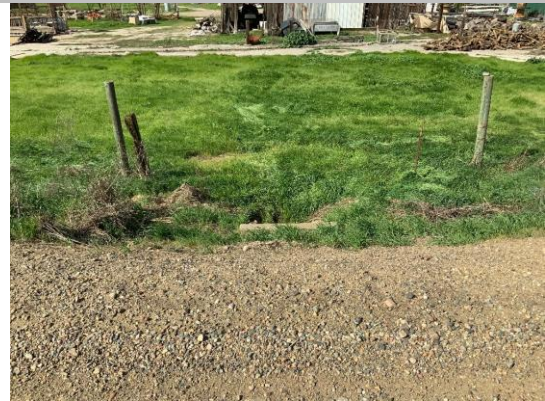
Photo 1 of 3 : UCIP_FA_2022_77334_92282.jpg

DS_ID:23508
 FS_ID:77334
 EP_NO: N/A
 Repair Type: Non-Urgent
 EVAL Issue: 5, Pipe Damage
 Crossing Status: Found
 UCIP Comments: 02/25/2021 The record has been upgraded from No Action Needed to Non-Urgent. DWR DMP has found integrity issues, LOF between 4 and 5. Crossing will be monitored until funding becomes available for rehabilitation. Recommend maintenance to clear up sediment buildup through LS pipe. No permit was found authorizing this encroachment. CVFPB will need to review crossing to determine owner. The UCIP inspection was completed with LMA representative, M. McCoy. (H. Dunn – GEI)
 FIELD_STRUCT_DESC: 24-inch corrugated metal storm drainage pipe (CMP) through the levee, 7.5 feet below the crown. Flap gate on the waterside (WS) end. Concrete U-shaped headwalls on both ends. Cobble grouted spillway across the berm. Cobble grouted apron on the landside (LS) end. [Additional Reference(s): DWR Levee Log, 1987, (HLM 12.72). USACE San Joaquin O&M Manual 612.2, 1967, (HLM 12.72), and 612 (addendum), February 1999, (HLM 12.71), (Station 671+24)].

LS view: LS headwall at toe from crown.

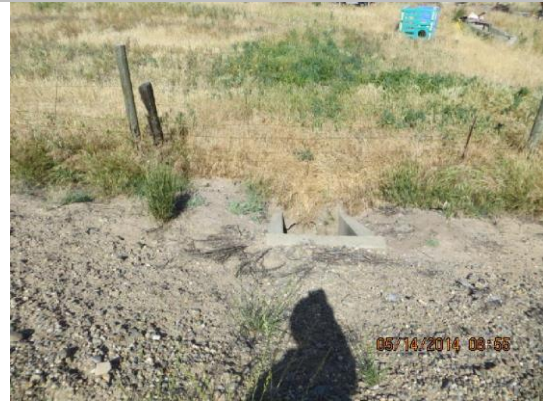
Photo 2 of 3 : UCIP_FA_2022_77334_68555.jpg

Pipe and headwall at LS toe.

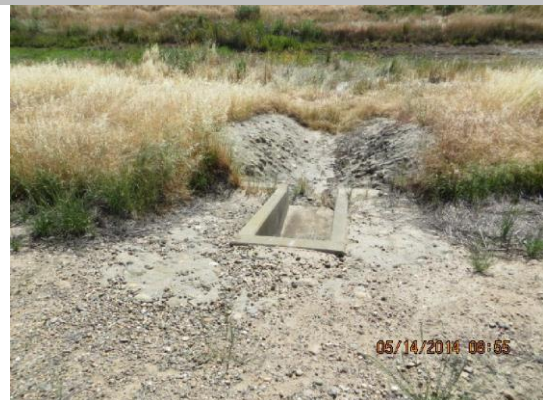
Photo 3 of 3 : UCIP_FA_2022_77334_68554.jpg

Pipe, flapgate, headwall, and grouted spillway on WS toe.

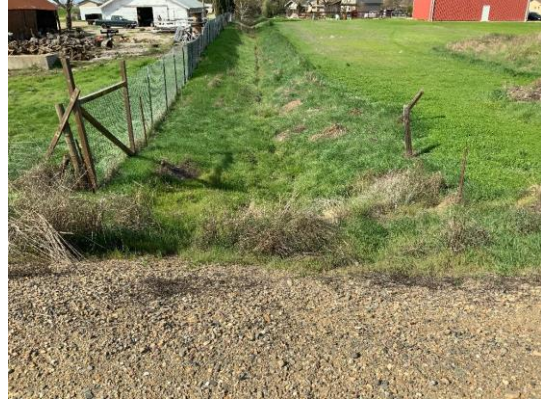
Photo 1 of 3 : UCIP_FA_2022_77335_92291.jpg

Comment Code						
Inspector Comment						
DS_ID:23509 FS_ID:77335 EP_NO: N/A Repair Type: Non-Urgent EVAL Issue: Crossing Status: Found UCIP Comments: 02/25/2021 The record has been upgraded from No Action Needed to Non-Urgent. DWR DMP internal inspection has not found pipe integrity issues. LOF of crossing is less or equal to 4.0. Recommend next video inspection in 5 years. No permit was found authorizing this encroachment. CVFPB will need to review crossing to determine owner. The UCIP inspection was completed with LMA representative, M. McCoy. (H. Dunn – GEI) FIELD_STRUCT_DESC: 24-inch corrugated metal storm drainage pipe (CMP) through the levee, 7.5 feet below the crown. Flap gate on the waterside (WS) end. Concrete U-shaped headwalls on both ends. Cobble grouted spillway across the berm. Cobble grouted apron on the landside (LS) end. [Additional Reference(s): DWR Levee Log, 1987, (HLM 12.74). USACE San Joaquin O&M Manual 612.2, 1967, (HLM 12.74), and 612 (addendum), February 1999, (HLM 12.73), (Station 672+05)]. FS Date: 2/25/2021

LS view: LS headwall at toe from crown.

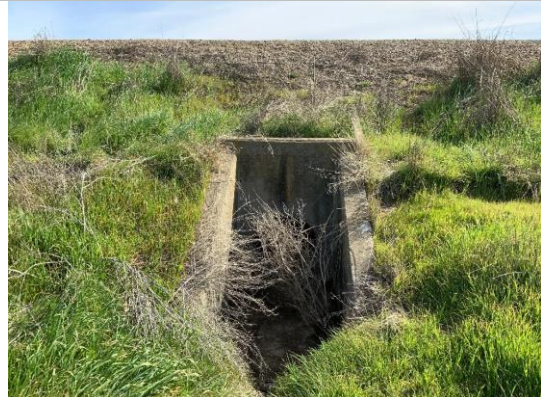
Photo 2 of 3 : UCIP_FA_2022_77335_95682.jpg

LS view: Headwall at toe.

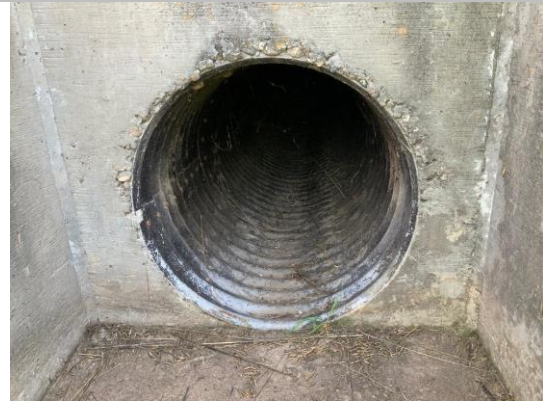
Photo 3 of 3 : UCIP_FA_2022_77335_95683.jpg

LS view: Pipe inlet, 1 of 2 photos.

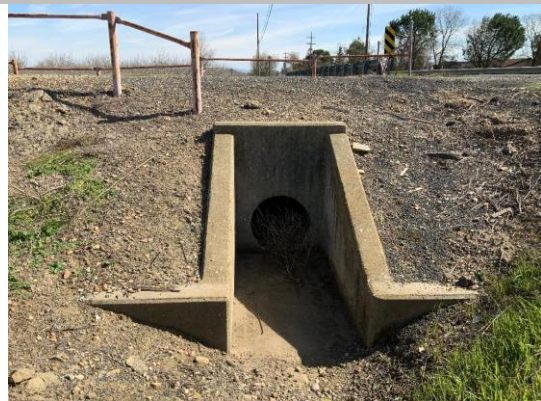
Photo 2 of 3 : UCIP_FA_2022_77340_92341.jpg

LS view: LS headwall at toe.

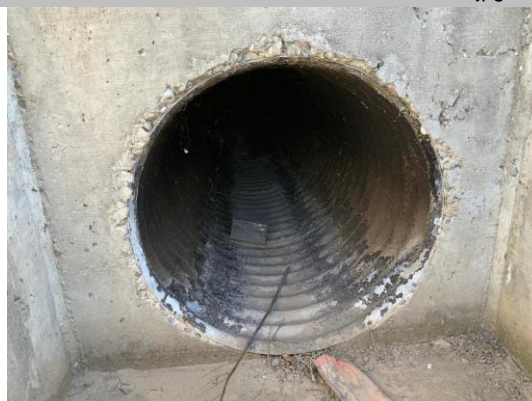
Photo 3 of 3 : UCIP_FA_2022_77340_92342.jpg

LS view: LS pipe.

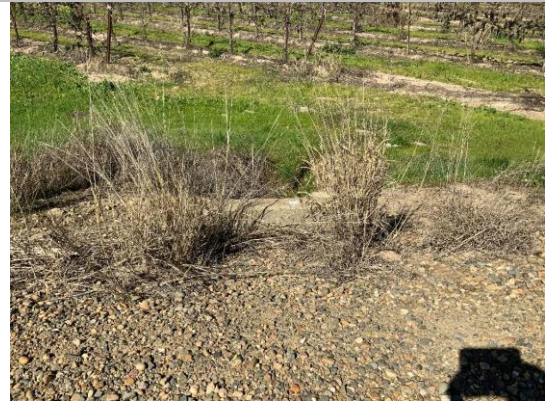
Photo 1 of 3 : UCIP_FA_2022_77346_92446.jpg

Comment Code						
Inspector Comment						
DS_ID:23597 FS_ID:77346 EP_NO: N/A Repair Type: Non-Urgent EVAL Issue: Crossing Status: Found UCIP Comments: 02/25/2021 The record has been upgraded from No Action Needed to Non-Urgent. DWR DMP has not found internal issues, LOF between 1 and 2. Recommend inspection in 5 years. No permit was found authorizing this encroachment. CVFPB will need to review crossing to determine owner. The UCIP inspection was completed with LMA representative, M. McCoy. (H. Dunn – GEI) FIELD_STRUCT_DESC: 24-inch corrugated metal storm drainage pipe (CMP) through the levee, 5.5 feet below the crown. Flap gate on the waterside (WS) end. Concrete U-shaped headwalls on both ends. Cobble grouted spillway. Cobble grouted intake on the landside (LS). [Additional Reference(s): DWR Levee Log, 1987, (HLM 13.64). USACE San Joaquin O&M Manual 612.2, 1967, (HLM 13.64)]. FS Date: 2/25/2021

LS view: LS headwall at toe from crown.

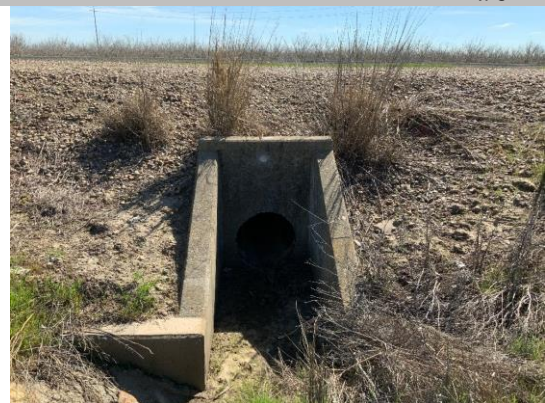
Photo 2 of 3 : UCIP_FA_2022_77346_92447.jpg

LS view: LS headwall at toe.

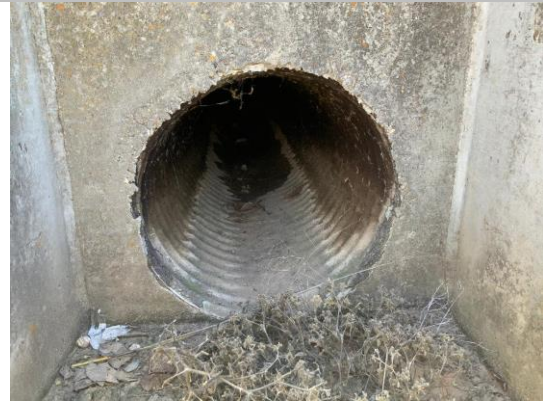
Photo 3 of 3 : UCIP_FA_2022_77346_92448.jpg

LS view: LS pipe.

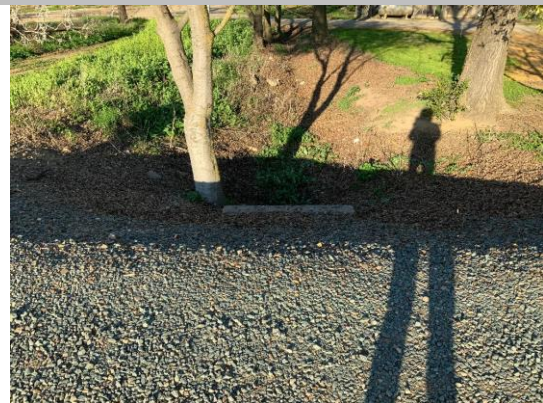
Photo 1 of 3 : UCIP_FA_2022_77347_92704.jpg

DS_ID:23598
 FS_ID:77347
 EP_NO: N/A
 Repair Type: Non-Urgent
 EVAL Issue:
 Crossing Status: Found
 UCIP Comments: 02/26/2021 The record has been upgraded from No Action Needed to Non-Urgent. DWR DMP has not found internal issues, LOF between 1 and 2. Recommend inspection in 5 years. No permit was found authorizing this encroachment. CVFPB will need to review crossing to determine owner. The UCIP inspection was completed with LMA representative, J. Caruso. (H. Dunn – GEI)
 FIELD_STRUCT_DESC: 24-inch corrugated metal storm drainage pipe (CMP) through the levee, 7.5 feet below the crown. Flap gate on the waterside (WS) end. Concrete U-shaped headwalls on both ends. Cobble grouted spillway. Cobble grouted intake on the landside (LS) slope. [Additional Reference(s): DWR Levee Log, 1987, (HLM 14.04). USACE San Joaquin O&M Manual 612.2, 1967, (HLM 14.04)].
 FS Date: 2/26/2021

LS headwall at toe from crown.

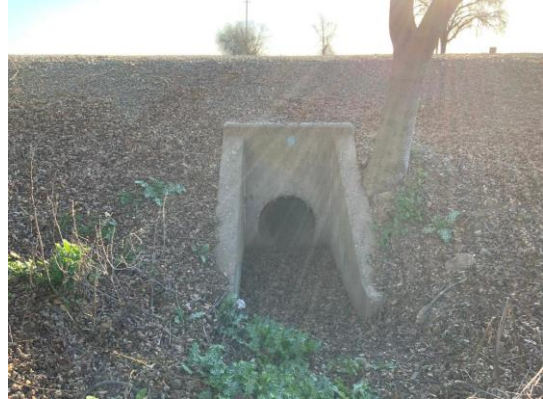
Photo 2 of 3 : UCIP_FA_2022_77347_92705.jpg

LS headwall at toe.

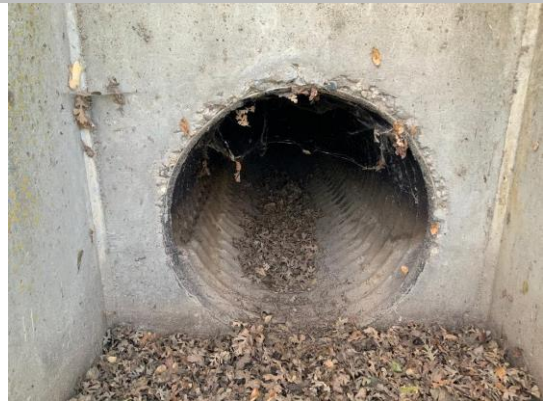
Photo 3 of 3 : UCIP_FA_2022_77347_92706.jpg

LS pipe.

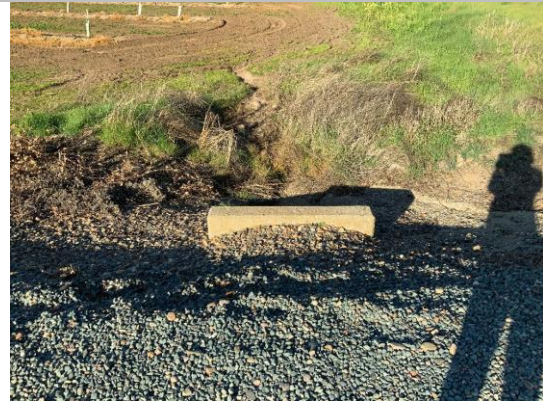
Photo 1 of 3 : UCIP_FA_2022_77350_92726.jpg

Comment Code					
Inspector Comment					
DS_ID:23600 FS_ID:77350 EP_NO: N/A Repair Type: Non-Urgent EVAL Issue: Crossing Status: Found UCIP Comments: 02/26/2021 The record has been upgraded from No Action Needed to Non-Urgent. DWR DMP has not found internal issues, LOF between 1 and 2. Recommend inspection in 5 years. No permit was found authorizing this encroachment. CVFPB will need to review crossing to determine owner. The UCIP inspection was completed with LMA representative, J. Caruso. (H. Dunn – GEI) FIELD_STRUCT_DESC: 24-inch corrugated metal storm drainage pipe (CMP) through the levee, 6.0 feet below the crown. Flap gate on the waterside (WS) end. Concrete U-shaped headwalls on both ends. Cobble grouted spillway. [Additional Reference(s): DWR Levee Log, 1987, (HLM 14.37). USACE San Joaquin O&M Manual 612.2, 1967, (HLM 14.37)]. FS Date: 2/26/2021

LS view: LS headwall at toe from crown.

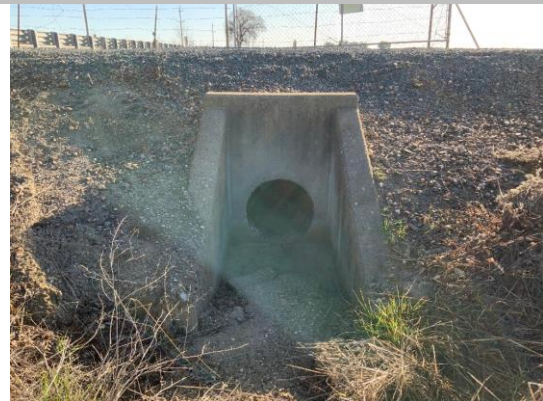
Photo 2 of 3 : UCIP_FA_2022_77350_92727.jpg

LS view: LS headwall at toe.

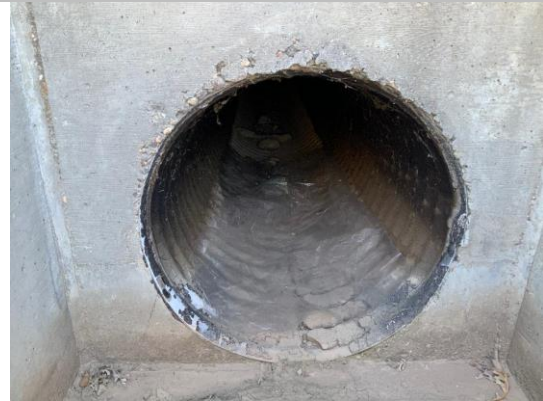
Photo 3 of 3 : UCIP_FA_2022_77350_92728.jpg

LS view: LS pipe.

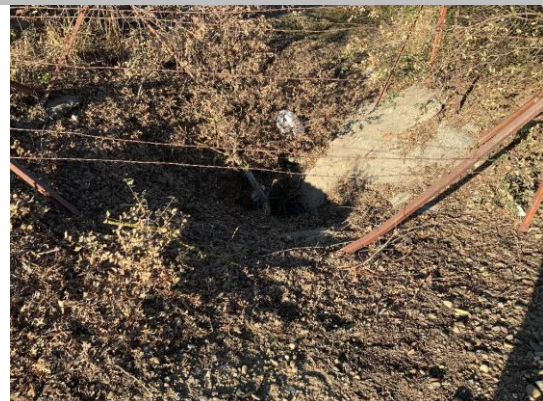
Photo 1 of 3 : UCIP_FA_2022_77352_92737.jpg

DS_ID:23601
 FS_ID:77352
 EP_NO: N/A
 Repair Type: Non-Urgent
 EVAL Issue: 5, Pipe Damage
 Crossing Status: Found
 UCIP Comments: 02/26/2021 Record record has been updated from No Action Needed to Non-Urgent. DWR DMP has found integrity issues, LOF between 4 and 5. Crossing will be monitored until funding becomes available for rehabilitation. No permit was found authorizing this encroachment. CVFPB will need to review crossing to determine owner. The UCIP inspection was completed with LMA representative, J. Caruso. (H. Dunn GEI)
 FIELD_STRUCT_DESC: 24-inch corrugated metal storm drainage pipe (CMP) through the levee, 8.0 feet below the crown. Flap gate on the waterside (WS) end. Concrete U-shaped headwall on the WS end. Cobble grouted spillway. 24-inch CMP drop inlet and cobble grouted intake on the landside (LS), no headwall. (Drainage ditch and 12-inch culverts adjacent to levee installed under Permit No. 12659, 1979 - Richard Stasand). [Additional Reference(s): DWR Levee Log, 1987, (HLM 14.39). USACE San Joaquin O&M Manual 612.2, 1967, (HLM 14.39)].

LS view: LS toe inlet, surrounded by barbed wire.

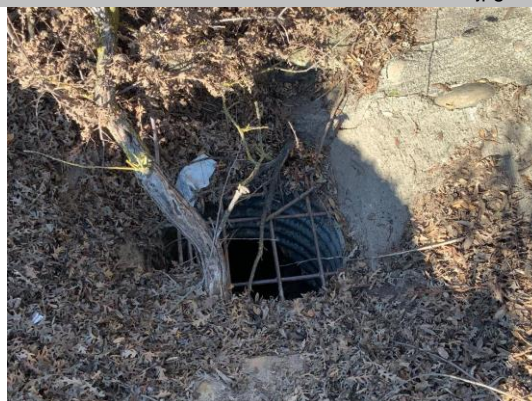
Photo 2 of 3 : UCIP_FA_2022_77352_92738.jpg

LS view: LS toe pipe and inlet.

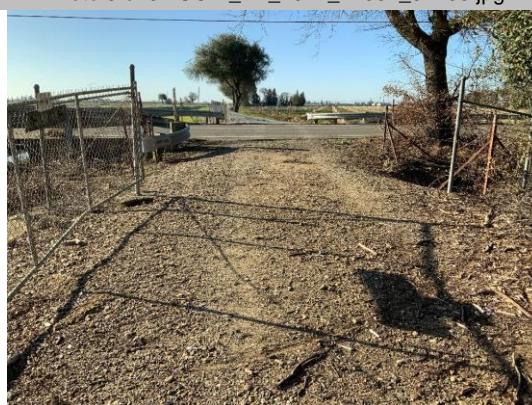
Photo 3 of 3 : UCIP_FA_2022_77352_92733.jpg

Levee crown looking downstream.

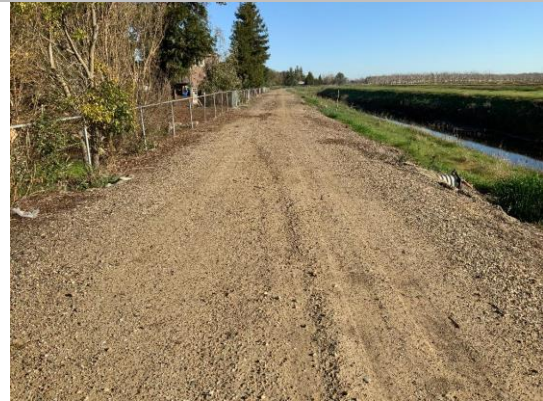
Photo 1 of 3 : UCIP_FA_2022_77353_92758.jpg

Comment Code					
Inspector Comment					
DS_ID:23602 FS_ID:77353 EP_NO: N/A Repair Type: Urgent EVAL Issue: 1, Pipe Integrity Crossing Status: Found UCIP Comments: 02/26/2021 Record has been updated from No Action Needed to Urgent. DWR DMP has found integrity issues, LOF between 5 and 6. Recommend monitoring crossing until funding becomes available to address. LS spillway is slightly overgrown with vegetation. No permit was found authorizing this encroachment. CVFPB will need to review crossing to determine owner. LS flap gate is broken and needs repair. The UCIP inspection was completed with LMA representative, J. Caruso. (H. Dunn – GEI) FIELD_STRUCT_DESC: 12-inch corrugated metal drainage pipe (CMP) through the levee, 1.0 foot below the crown. Cobble grouted inlet at fish pond on the landside (LS) toe. [Additional Reference(s): DWR Levee Log, 1987, (HLM 14.42), 7-inch pipe listed. USACE San Joaquin O&M Manual 612.2, 1967, (HLM 14.42), 7-inch pipe listed]. FS Date: 2/26/2021

Levee crown looking upstream.

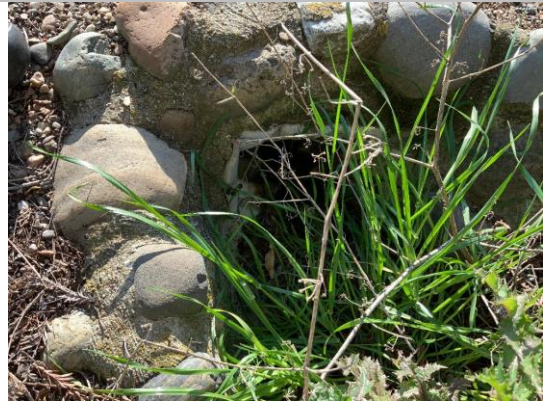
Photo 3 of 3 : UCIP_FA_2022_77353_92760.jpg

LS view: LS pipe at toe.

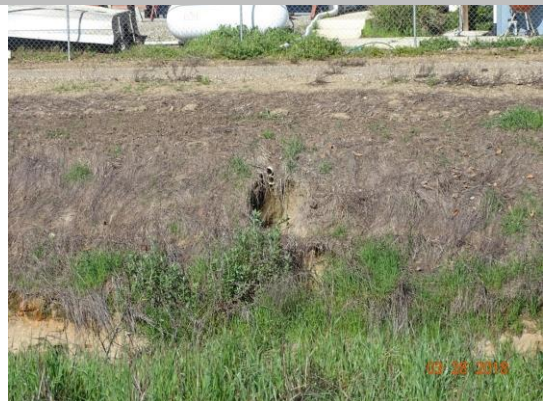
Photo 1 of 2 : FA_2022_NA0017_151_179_20220919_00017.jpg

LM Start	14.01	Rating **	U	Issue No.	179
LM End	14.01	Issue Type +	Ma	Location *	WS
Category	Earthen Levee			GPS Latitude/Longitude	
				Start	End
Item	Erosion / Bank Caving			38.118779 °	38.118779 °
				-121.171325 °	-121.171325 °
DWR ID	DWR_NA0017_07_s_2018_179				
Comment Code					
E2 : Schedule repair of erosion site prior to the next inspection.					
Inspector Comment					
Erosion on the waterside is caused by 2 pipe outlets.

NA17 SJCF&WCD Unit 7 Issue 179 LM14.01 erosion waterside photo from opposite side of channel looking west.

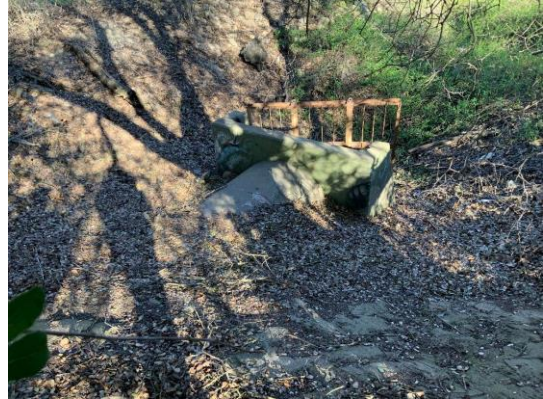
Photo 1 of 3 : UCIP_FA_2022_77357_92790.jpg

Comment Code					
Inspector Comment					
DS_ID:23604 FS_ID:77357 EP_NO: N/A Repair Type: Non-Urgent EVAL Issue: 11, Maintenance Compliance Issue Crossing Status: Found UCIP Comments: 02/26/2021 Record remains Non-Urgent. Unit 7 – Bear Creek (CLM 13.95 to 14.90) is considered a patrol road/high ground area with no defined levee prism, any issue found between CLM 13.95 to 14.90 of Unit 7 will be considered a maintenance issue, or an unauthorized encroachment, or an abandoned encroachment. DWR DMP has found integrity issues, LOF between 4 and 5. Current condition of pipe crossing does not impede access to patrol road/high ground area. No permit was found authorizing this encroachment. CVFPB will need to review crossing to determine owner.. The UCIP inspection was completed with LMA representative, J. Caruso. (H. Dunn – GEI) 05/12/2014 No flapgate. (W. Wylie - DWR UCIP) FIELD_STRUCT_DESC: 48-inch reinforced concrete drainage pipe (RCP) through the levee, 9.0 feet below the crown. Concrete headwall with trash rack on the landside (LS). Cobble grouted intake on the LS. Cobble grouted spillway on the waterside (WS). Open on both ends. [Additional Reference(s): DWR Levee Log, 1987, (HLM 15.00). USACE San Joaquin O&M Manual 612.2, 1967, (HLM 15.00)]. FS Date: 2/26/2021

LS view: LS headwall off of the toe.

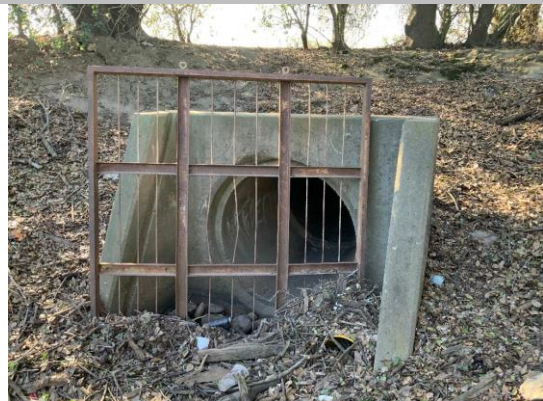
Photo 2 of 3 : UCIP_FA_2022_77357_92791.jpg

LS view: LS headwall, gate adjar, no flapgate.

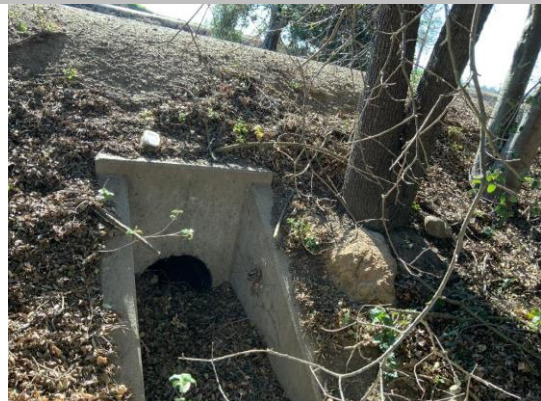
Photo 2 of 3 : UCIP_FA_2022_77361_92825.jpg

LS view: LS headwall at toe.

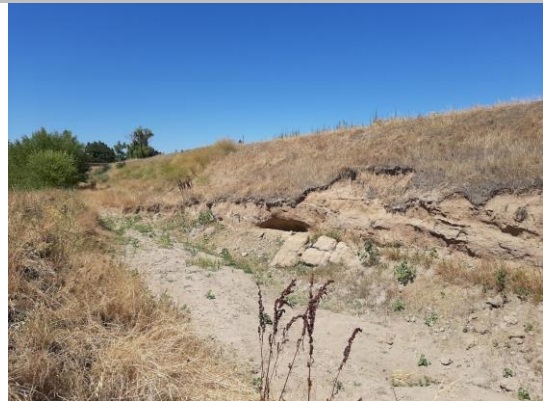
Photo 1 of 2 : SJR2022_NA0017U07RM22.33_4.jpg

*This area is patrol road only and therefore the site is not rated
07/13/2022: No significant changes were observed during the annual survey.

06/22/2021: The site was discovered during the field survey. The erosion is immediately downstream of a bend. There is visible undercutting and caving approximately 5 ft below the crown with a scarp height of 3 ft.

7/13/2022: View of the erosion looking downstream.

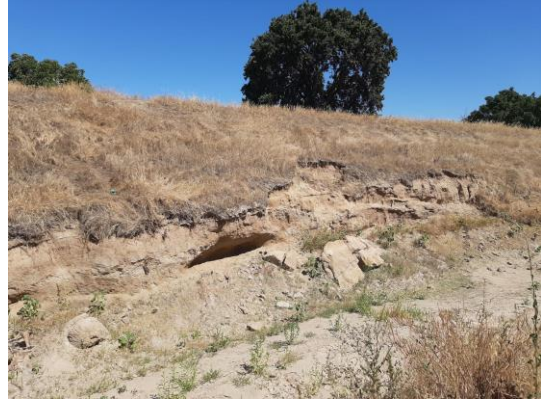
Photo 2 of 2 : SJR2022_NA0017U07RM22.33_5.jpg

7/13/2022: View of the erosion looking upstream.

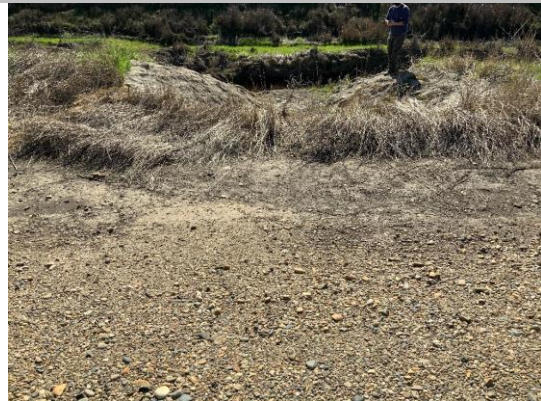
Photo 1 of 3 : UCIP_FA_2022_77367_92893.jpg

UCIP Comments: 02/26/2021 The record has been upgraded from No Action Needed to Non-Urgent. DWR DMP has not found internal issues, LOF between 1 and 2. Recommend inspection in 5 years. No permit was found authorizing this encroachment. CVFPB will need to review crossing to determine owner. The UCIP inspection was completed with LMA representative, J. Caruso. (H. Dunn – GEI)

FIELD_STRUCT_DESC: 24-inch corrugated metal storm drainage pipe (CMP) through the levee, 7.5 feet below the crown. Flap gate on the waterside (WS) end. Concrete U-shaped headwalls on both ends. Cobble grouted spillway. Cobble grouted intake on the landside (LS). [Additional Reference(s): DWR Levee Log, 1987, (HLM 15.68). USACE San Joaquin O&M Manual 612.2, 1967, (HLM 15.68)]. FS Date: 2/26/2021

WS view: WS headwall at toe from crown.

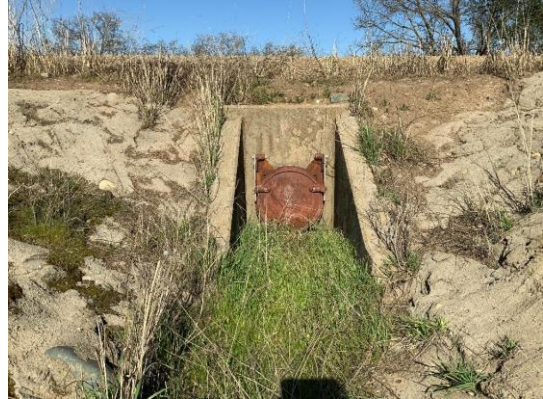
Photo 2 of 3 : UCIP_FA_2022_77367_92894.jpg

WS view: WS headwall and flapgate at toe.

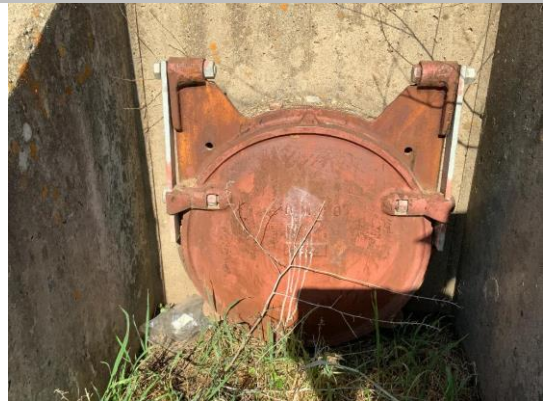
Photo 3 of 3 : UCIP_FA_2022_77367_92895.jpg

WS view: WS flapgate.

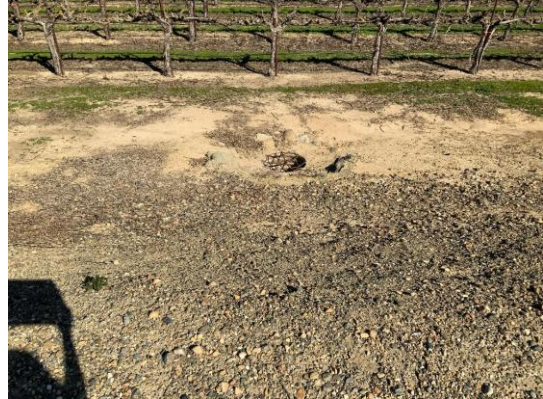
Photo 1 of 3 : UCIP_FA_2022_77381_92905.jpg

Comment Code						
Inspector Comment						
DS_ID:23610 FS_ID:77381 EP_NO: N/A Repair Type: Non-Urgent EVAL Issue: 4b, Safety Issue Crossing Status: Found UCIP Comments: 02/26/2021 Pipe status is still Non-Urgent. LS inlet only has wiring covering it, no cover or riser, safety concern. DWR DMP has not found internal issues, LOF between 1 and 2. Recommend inspection in 5 years. No permit was found authorizing this encroachment. CVFPB will need to review crossing to determine owner. The UCIP inspection was completed with LMA representative, J. Caruso. (H. Dunn – GEI) 05/12/2014 No inlet cover or grate at LS toe. (W. Wylie - DWR UCIP) FIELD_STRUCT_DESC: 24-inch corrugated metal storm drainage pipe (CMP) through the levee, 11.0 feet below the crown. Flap gate on the waterside (WS) end. Concrete U-shaped headwall on the WS end. 24-inch CMP riser unit/drop inlet on the landside (LS). [Additional Reference(s): DWR Levee Log, 1987, (HLM 15.80). USACE San Joaquin O&M Manual 612.2, 1967, (HLM 15.80)]. FS Date: 2/26/2021

LS view: LS toe from crown, pipe inlet with no riser.

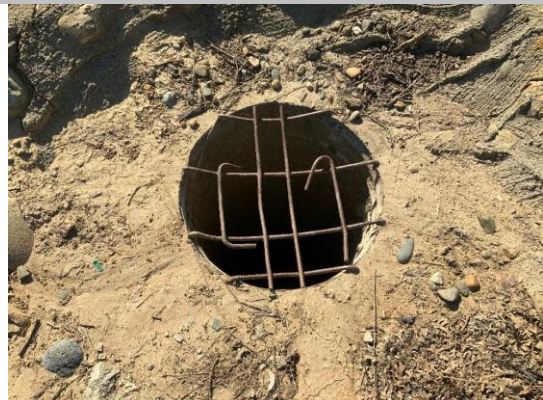
Photo 2 of 3 : UCIP_FA_2022_77381_92906.jpg

LS view: LS pipe inlet, no cover, safety concern.

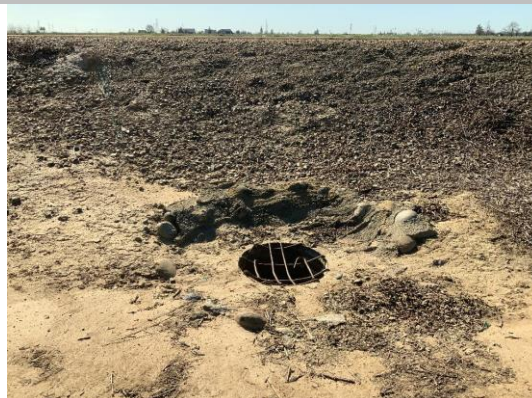
Photo 3 of 3 : UCIP_FA_2022_77381_92907.jpg

LS view: LS pipe inlet at toe, safety concern.

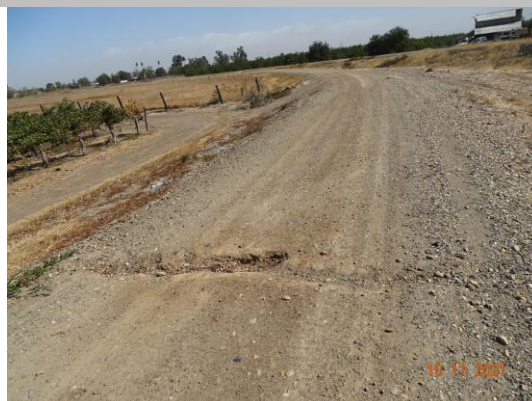
Photo 1 of 1 : FA_2022_NA0017_151_258_20220919_00029.jpg

LM Start	15.29	Rating **	M	Issue No.	258
LM End	15.29	Issue Type +	Ma	Location *	CR
Category	Earthen Levee			GPS Latitude/Longitude	
				Start	End
Item	Crown Surface / Depressions / Rutting			38.130319 °	38.130319 °
				-121.156006 °	-121.156006 °
DWR ID	DWR_NA0017_07_f_2021_258				
Comment Code					
C2 : Repair depressions or ruts in the crown or slope.					
Inspector Comment

View of depression within the crown surface. Fall 2021

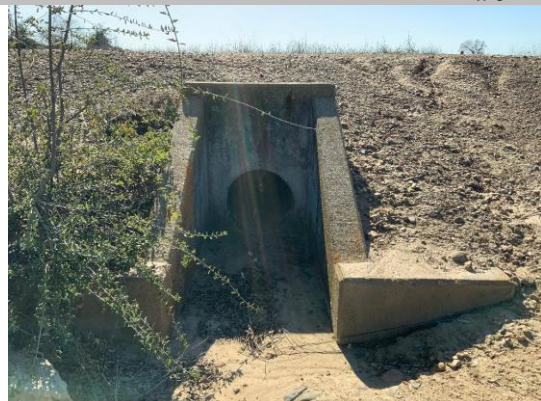
Photo 2 of 3 : UCIP_FA_2022_77369_92921.jpg

LS view: LS headwall at toe.

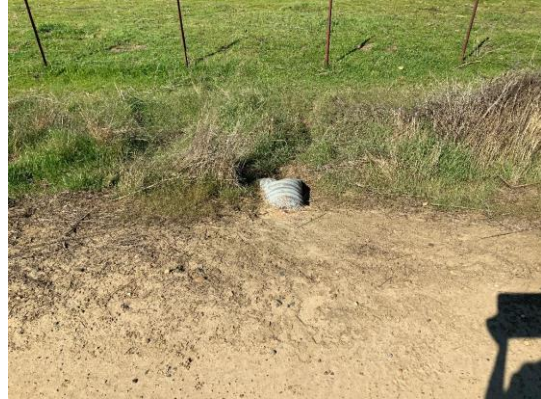
Photo 1 of 3 : UCIP_FA_2022_77380_92931.jpg

Comment Code					
Inspector Comment					
DS_ID:23612 FS_ID:77380 EP_NO: N/A Repair Type: Non-Urgent EVAL Issue: 11, Maintenance Compliance Issue Crossing Status: Found UCIP Comments: 02/26/2021 Record remains Non-Urgent. Unit 7 – Bear Creek (CLM 15.50 to 16.13) is considered a patrol road/high ground area with no defined levee prism, any issue found between CLM 15.50 to 16.13 of Unit 7 will be considered a maintenance issue, or an unauthorized encroachment, or an abandoned encroachment. Current condition of pipe crossing does not impede access to patrol road/high ground area. Pipe is open on both ends and LS pipe edges are severely bent, recommend maintenance. No permit was found authorizing this encroachment. CVFPB will need to review crossing to determine owner. The UCIP inspection was completed with LMA representative, J. Caruso. (H. Dunn - GEI) 09/18/2018 Levee is so short that it's almost nonexistent. Pipe goes just under levee and acts as an open storm drain. Inlet is bent down. There is a flooding potential because this pipe is open and goes straight through the levee; therefore, this crossing remains "Urgent." (A. McDonald - DWR UCIP)04/20/2017 Pipe is open on both ends. Requires a positive closure device. Crossing has been upgraded from No Action Needed to Urgent. (K. Fazel - UCIP) FIELD_STRUCT_DESC: 12-inch corrugated metal drainage culvert pipe (CMP) through the levee, 1.5 feet below the crown. Cobble grouted spillway. Open on both ends. [Additional Reference(s): DWR Levee Log, 1987, (HLM 16.09). USACE San Joaquin O&M Manual 612.2, 1967, (HLM 16.10)]. FS Date: 2/26/2021

LS view: LS pipe at toe from crown.

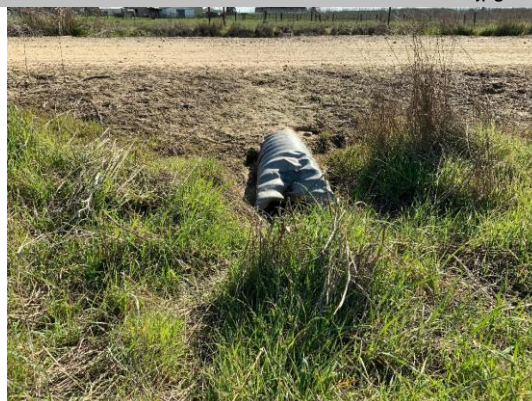
Photo 2 of 3 : UCIP_FA_2022_77380_92924.jpg

LS view: LS pipe at toe.

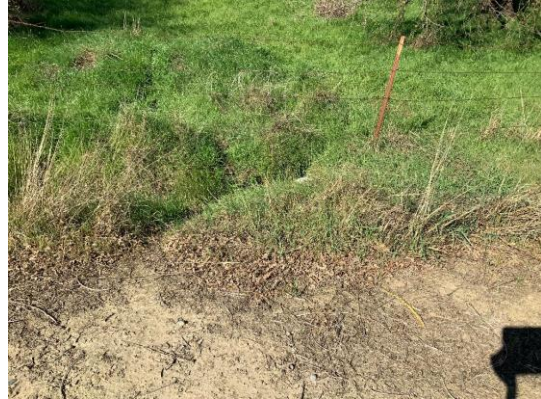
Photo 1 of 3 : UCIP_FA_2022_77372_92948.jpg

Comment Code						
Inspector Comment						
DS_ID:23614 FS_ID:77372 EP_NO: N/A Repair Type: Non-Urgent EVAL Issue: 11, Maintenance Compliance Issue Crossing Status: Found UCIP Comments: 02/26/2021 Record remains Non-Urgent. Unit 7 – Bear Creek (CLM 15.50 to 16.13) is considered a patrol road/high ground area with no defined levee prism, any issue found between CLM 15.50 to 16.13 of Unit 7 will be considered a maintenance issue, or an unauthorized encroachment, or an abandoned encroachment. Pipe is barely a foot below crown and open on both WS and LS toes. WS has bad erosion and large burrow holes under and around it, recommend maintenance for open pipe and erosion. Pipe is surrounded by large pieces of broken concrete. No permit was found authorizing this encroachment. CVFPB will need to review crossing to determine owner. The UCIP inspection was completed with LMA representative, J. Caruso. (H. Dunn – GEI) 009/18/2018 Levee is so short that it's almost nonexistent. Pipe goes just under levee and acts as an open storm drain. There is a flooding potential because this pipe is open and goes straight through the levee; therefore, this crossing remains "Urgent." (A. McDonald - DWR UCIP)04/20/2017 Pipe is open on both ends. Requires a positive closure device. Crossing has been upgraded from No Action Needed to Urgent. (K. Fazel - UCIP) FIELD_STRUCT_DESC: 12-inch corrugated metal drainage culvert pipe (CMP) through the levee, 2.0 feet below the crown. Cobble grouted spillway. Open on both ends. [Additional Reference(s): DWR Levee Log, 1987, (HLM 16.32). USACE San Joaquin O&M Manual 612.2, 1967, (HLM 16.32)]. FS Date: 2/26/2021

LS view: LS pipe at toe from crown.

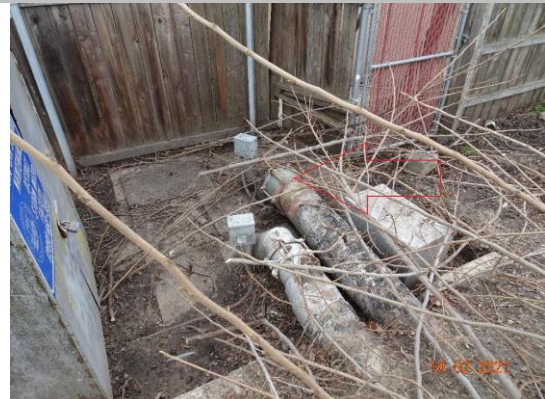
Photo 2 of 3 : UCIP_FA_2022_77442_93422.jpg

Comment Code						
Inspector Comment						
DS_ID:23731 FS_ID:77442 EP_NO: N/A Repair Type: Non-Urgent EVAL Issue: Crossing Status: Found UCIP Comments: 02/16/2021 Record was updated from No Action Needed to Non-Urgent. No permit was found authorizing this encroachment. CVFPB will need to review crossing to determine owner. Briar bush overgrowth limiting visual of WS toe. Working meter and control panel belonging Rancho San Joaquin Maintenance District Storm Water Facility at LS toe. LMA representative indicated utility belongs to the City of Stockton. The UCIP inspection was completed with DWR Inspector, O. Magana, and LMA representative, J. Caruso. (N. Cholewinski - GEI) FIELD_STRUCT_DESC: [Rancho San Joaquin Maintenance District Storm Water Facility] 1 of 2: 10-inch soil proofed steel drainage pipe through the levee, 3.0 feet below the crown. Flap gates on the waterside (WS) end. Siphon breaker inside a 24-inch corrugated metal pipe (CMP) riser unit on the WS slope. Pumps mounted over a 6-foot by 7-foot concrete sump at the landside (LS) toe. Pole and electrical panel at the same location. [Additional Reference(s): DWR Levee Log, 1990, (HLM 2.18). USACE San Joaquin O&M Manual 612.1, June 1965, (HLM 2.18)]. FS Date: 2/16/2021

LS View: Pipe visible at LS toe. Electrical control panel and post adjacent to utility.

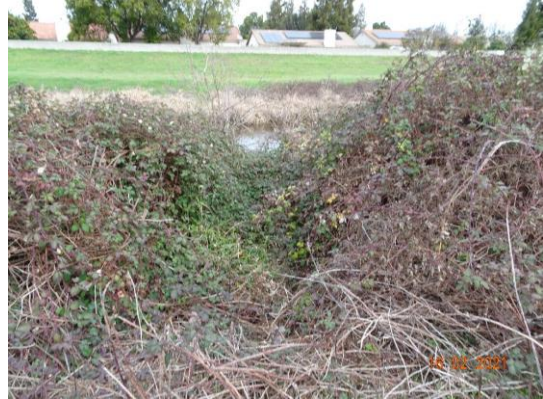
Photo 3 of 3 : UCIP_FA_2022_77442_93426.jpg

WS View: Briar bush overgrowth limiting visual of WS toe.

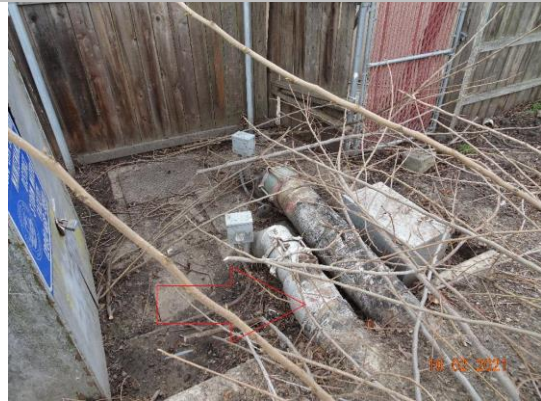
Photo 2 of 3 : UCIP_FA_2022_77443_93415.jpg

DS_ID:23821
 FS_ID:77443
 EP_NO: N/A
 Repair Type: Non-Urgent
 EVAL Issue:
 Crossing Status: Found
 UCIP Comments: 02/16/2021 Record was updated from No Action Needed to Non-Urgent. No permit was found authorizing this encroachment. CVFPB will need to review crossing to determine owner. Briar bush overgrowth limiting visual of WS toe. Working meter and control panel belonging Rancho San Joaquin Maintenance District Storm Water Facility at LS toe. LMA representative indicated utility belongs to the City of Stockton. The UCIP inspection was completed with DWR Inspector, O. Magana, and LMA representative, J. Caruso. (N. Cholewinski - GEI)
 FIELD_STRUCT_DESC: [Rancho San Joaquin Maintenance District Storm Water Facility] 2 of 2: 10-inch soil proofed steel drainage pipe through the levee, 3.0 feet below the crown. Flap gate on the waterside (WS) end. Siphon breaker inside a 24-inch corrugated metal pipe (CMP) riser unit on the WS shoulder. Pumps mounted over a 6-foot by 7-foot concrete sump at the landside (LS) toe. [Additional Reference(s): DWR Levee Log, 1990, (HLM 2.18). USACE San Joaquin O&M Manual 612.1, June 1965, (HLM 2.18)].

LS View: Pipe visible at LS toe. Electrical panel and post adjacent to pipe.

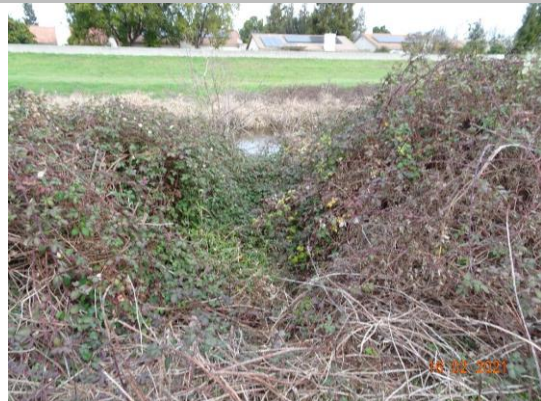
Photo 3 of 3 : UCIP_FA_2022_77443_93419.jpg

WS View: Briar bush overgrowth limiting visual of WS toe.

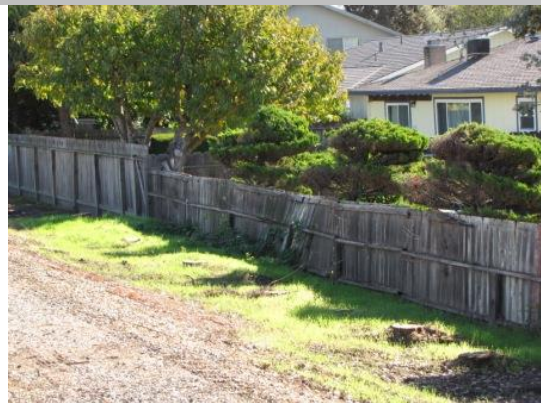
Photo 1 of 1 : FA_2022_NA0017_152_12_20220919_00003.jpg

LM Start	2.50	Rating **	N	Issue No.	12
LM End	2.50	Issue Type +	Ma	Location *	LS
Category	Earthen Levee			GPS Latitude/Longitude	
				Start	End
Item	Trim / Thin Trees			38.042749 °	38.042749 °
				-121.338402 °	-121.338402 °
DWR ID	DWR_NA0017_08_s_2012_12				
Comment Code					
T5 : Tree stumps.					
Inspector Comment

View of stumps along the landward toe looking upstream.

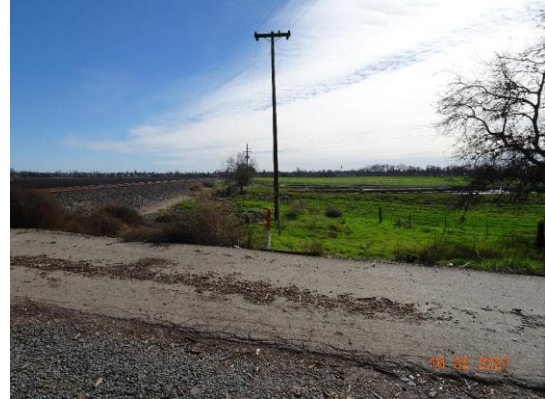
Photo 2 of 3 : UCIP_FA_2022_77457_93344.jpg

Comment Code						
Inspector Comment						
DS_ID:23734 FS_ID:77457 EP_NO: N/A Repair Type: Non-Urgent EVAL Issue: Crossing Status: Found UCIP Comments: 02/16/2021 Record was updated from No Action Needed to Non-Urgent. No permit was found authorizing this encroachment. CVFPB will need to review crossing to determine owner. DWR DMP has not found internal issues, LOF between 1 and 2. Recommend inspection in 5 years. Crack in headwall concrete visible on LS. Brush covering pipe opening on LS. Debris covering WS flapgate. The UCIP inspection was completed with DWR Inspector, O. Magana, and LMA representative, J. Caruso. (N. Cholewinski - GEI) FIELD_STRUCT_DESC: 24-inch corrugated metal drainage pipe (CMP) through the levee, 7.4 feet below the crown. Concrete U-shaped headwalls on both ends. Flap gate on the waterside (WS) end. Cobble grouted spillway across the berm. [Additional Reference(s): DWR Levee Log, 1990, (HLM 3.73). USACE San Joaquin O&M Manual 612.1, June 1965, (HLM 3.73)]. FS Date: 2/16/2021

LS View: Headwall at LS toe.

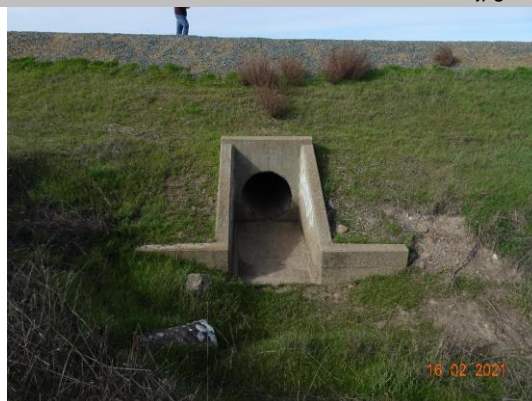
Photo 2 of 3 : UCIP_FA_2022_77463_93309.jpg

DS_ID:23736
 FS_ID:77463
 EP_NO: N/A
 Repair Type: Non-Urgent
 EVAL Issue:
 Crossing Status: Found
 UCIP Comments: 02/16/2021 Record was updated from No Action Needed to Non-Urgent. No permit was found authorizing this encroachment. CVFPB will need to review crossing to determine owner. DWR DMP has not found internal issues, LOF between 1 and 2. Recommend inspection in 5 years. The UCIP inspection was completed with DWR Inspector, O. Magana, and LMA representative, J. Caruso. (N. Cholewinski - GEI)
 FIELD_STRUCT_DESC: 36-inch corrugated metal storm drainage pipe (CMP) through the levee, 9.0 feet below the crown. Concrete U-shaped headwalls on both ends. Flap gate on the waterside (WS) end. Grouted intake on the landside (LS). Cobble grouted spillway across the berm. [Additional Reference(s): DWR Levee Log, 1990, (HLM 4.65). USACE San Joaquin O&M Manual 612.1, June 1965, (HLM 4.65), and 612 (addendum), February 1999, (HLM 4.82), (Station 254+24)].

LS View: Headwall at LS toe.

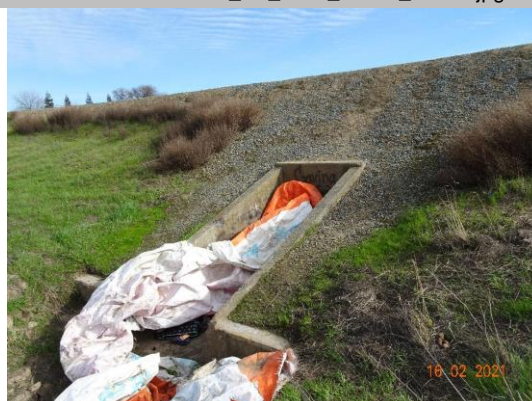
Photo 3 of 3 : UCIP_FA_2022_77463_93313.jpg

WS View: Headwall and flapgate at WS slope. Debris present.

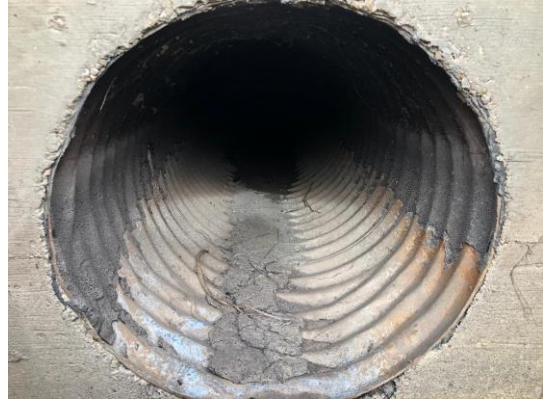
Photo 2 of 3 : UCIP_FA_2022_77475_93246.jpg

Comment Code						
Inspector Comment						
DS_ID:23709						
FS_ID:77475						
EP_NO: N/A						
Repair Type: Non-Urgent						
EVAL Issue:						
Crossing Status: Found						
UCIP Comments: 02/18/2021 Record was updated from No Action						
Needed to Non-Urgent. No permit was found authorizing this						
encroachment. CVFPB will need to review crossing to determine owner.						
DWR DMP has not found internal issues, LOF between 1 and 2.						
Recommend inspection in 5 years. LS pipe interior coating is						
weathering slightly. Small piece of concrete is broken off headwall on						
LS, not a integrity issue. The UCIP inspection was completed with						
DWR Inspector, S. Donovan, and LMA representative, J. Caruso. (N.						
Cholewinski - GEI)						
FIELD_STRUCT_DESC: 24-inch corrugated metal storm drainage pipe						
(CMP) through the levee, 6.9 feet below the crown. Concrete U-shaped						
headwalls on both ends. Flap gate on the waterside (WS) end. Grouted

LS View: Pipe at LS toe.
