**Flood Control Project Maintenance
Levee Inspections**

Maintenance Issue Types Only, Levee Inspection Report By Mile - Fall 2022

San Joaquin County Flood Control and Water Conservation District

Waterway	Bank	Unit Miles	Inspection Start/End	Inspector
Unit No. 01 Littlejohn Creek	Left	2.59	10/13/2022 10/13/2022	Alberto De Leon

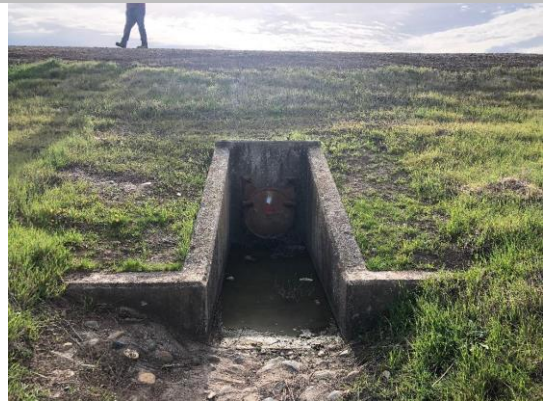
Photo 3 of 3 : UCIP_FA_2022_77475_93249.jpg

Comment Code						
Inspector Comment						
DS_ID:23709						
FS_ID:77475						
EP_NO: N/A						
Repair Type: Non-Urgent						
EVAL Issue:						
Crossing Status: Found						
UCIP Comments: 02/18/2021 Record was updated from No Action						
Needed to Non-Urgent. No permit was found authorizing this						
encroachment. CVFPB will need to review crossing to determine owner.						
DWR DMP has not found internal issues, LOF between 1 and 2.						
Recommend inspection in 5 years. LS pipe interior coating is						
weathering slightly. Small piece of concrete is broken off headwall on						
LS, not a integrity issue. The UCIP inspection was completed with						
DWR Inspector, S. Donovan, and LMA representative, J. Caruso. (N.						
Cholewinski - GEI)						
FIELD_STRUCT_DESC: 24-inch corrugated metal storm drainage pipe						
(CMP) through the levee, 6.9 feet below the crown. Concrete U-shaped						
headwalls on both ends. Flap gate on the waterside (WS) end. Grouted

WS View: Headwall and flapgate at WS slope.

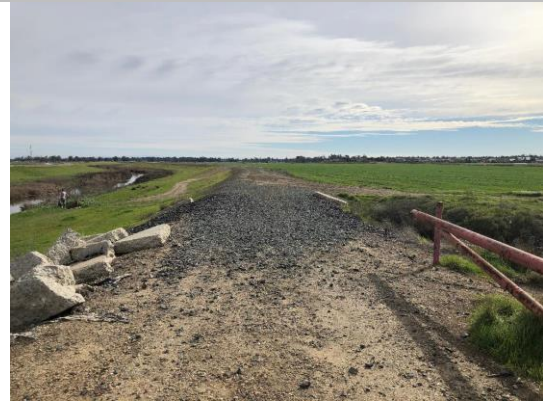
Photo 1 of 3 : UCIP_FA_2022_77478_93221.jpg

Comment Code						
Inspector Comment						
DS_ID:23711						
FS_ID:77478						
EP_NO: N/A						
Repair Type: Non-Urgent						
EVAL Issue:						
Crossing Status: Found						
UCIP Comments: 02/18/2021 Record was updated from No Action						
Needed to Non-Urgent. No permit was found authorizing this						
encroachment. CVFPB will need to review crossing to determine owner.						
DWR DMP has not found internal issues, LOF between 1 and 2.						
Recommend inspection in 5 years. Gravel observed above headwall on						
LS. The UCIP inspection was completed with DWR Inspector, S.						
Donovan, and LMA representative, J. Caruso. (N. Cholewinski - GEI)						
FIELD_STRUCT_DESC: 24-inch corrugated metal drainage pipe (CMP)						
through the levee, 7.3 feet below the crown. Concrete U-shaped						
headwalls on both ends. Flap gate on the waterside (WS) end. Grouted						
intake on the landside (LS). Cobble grouted spillway across the berm.

Crown Overview

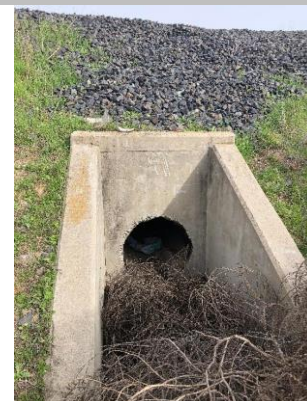
Photo 2 of 3 : UCIP_FA_2022_77478_93223.jpg

LS View: Headwall at LS toe.

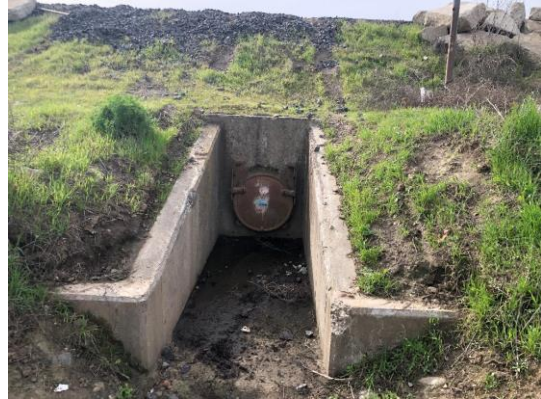
Photo 3 of 3 : UCIP_FA_2022_77478_93226.jpg

WS View: Headwall and 24-inch flapgate at WS toe.

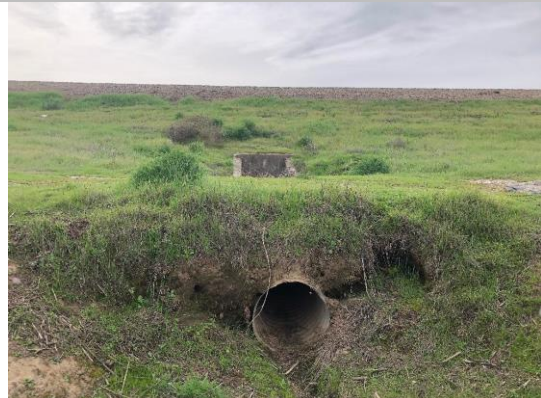
Photo 2 of 3 : UCIP_FA_2022_77488_93181.jpg

WS View: Headwall and flapgate at WS slope with pipe through WS berm.

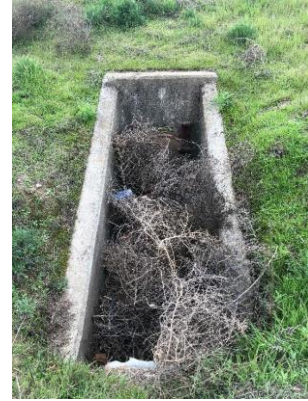
Photo 3 of 3 : UCIP_FA_2022_77488_93182.jpg

WS View: Headwall and flapgate at WS slope. Filled with tumble weeds.

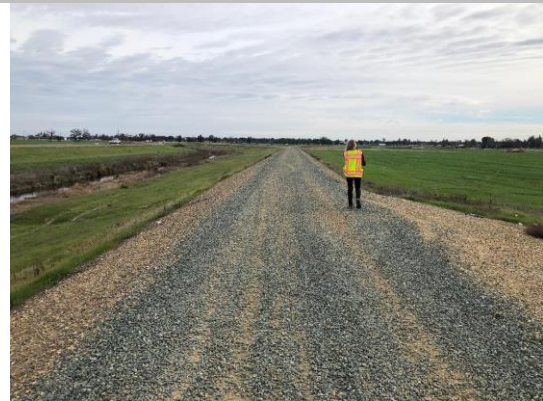
Photo 1 of 3 : UCIP_FA_2022_77490_93167.jpg

DS_ID:23714
 FS_ID:77490
 EP_NO: N/A
 Repair Type: Non-Urgent
 EVAL Issue:
 Crossing Status: Found
 UCIP Comments: 02/18/2021 Record was updated from No Action Needed to Non-Urgent. No permit was found authorizing this encroachment. CVFPB will need to review crossing to determine owner. DWR DMP has not found internal issues, LOF between 1 and 2. Recommend inspection in 5 years. Slight weathering of pipe interior coating at LS toe. The UCIP inspection was completed with DWR Inspector, S. Donovan, and LMA representative, J. Caruso. (N. Cholewinski - GEI)
 FIELD_STRUCT_DESC: 24-inch corrugated metal drainage pipe (CMP) through the levee, 8.5 feet below the crown. Concrete U-shaped headwalls on both ends. Flap gate on the waterside (WS) end. Grouted intake on the landside (LS). Cobble grouted spillway across the berm. [Additional Reference(s): DWR Levee Log, 1990, (HLM 6.56). USACE San Joaquin O&M Manual 612.1, June 1965, (HLM 6.56)].

Crown Overview

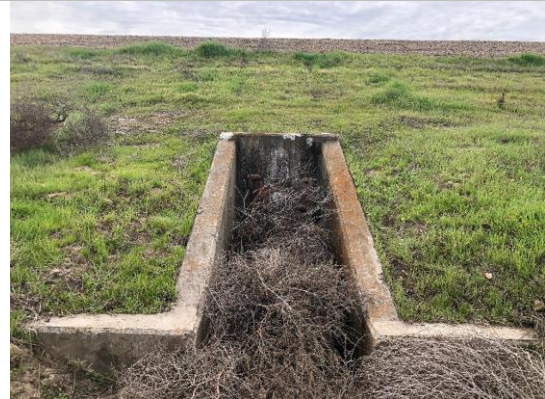
Photo 3 of 3 : UCIP_FA_2022_77490_93172.jpg

WS View: Headwall and flapgate at WS slope.

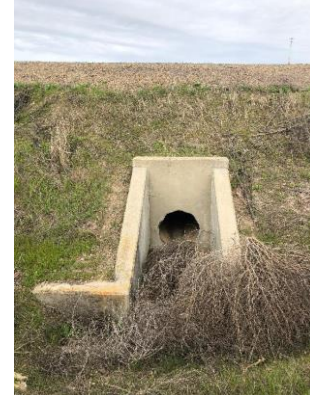
Photo 2 of 3 : UCIP_FA_2022_77491_93161.jpg

LS View: Headwall at LS toe.

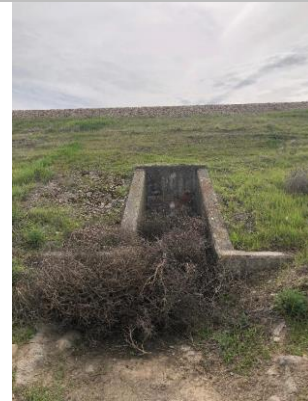
Photo 3 of 3 : UCIP_FA_2022_77491_93165.jpg

WS View: Headwall and flapgate at WS slope.

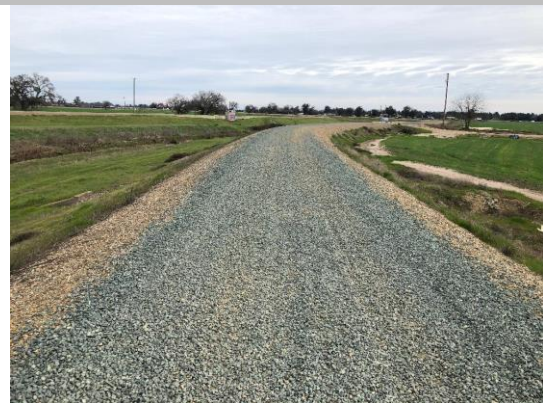
Photo 1 of 3 : UCIP_FA_2022_77492_93152.jpg

DS_ID:23716
 FS_ID:77492
 EP_NO: N/A
 Repair Type: Non-Urgent
 EVAL Issue:
 Crossing Status: Found
 UCIP Comments: 02/18/2021 Record was updated from No Action Needed to Non-Urgent. No permit was found authorizing this encroachment. CVFPB will need to review crossing to determine owner. DWR DMP has not found internal issues, LOF between 1 and 2. Recommend inspection in 5 years. The UCIP inspection was completed with DWR Inspector, S. Donovan, and LMA representative, J. Caruso. (N. Cholewinski - GEI)
 FIELD_STRUCT_DESC: 24-inch corrugated metal storm drainage pipe through the levee, 7.7 feet below the crown. Concrete U-shaped headwalls on both ends. Flap gate on the waterside (WS) end. Grouted intake on the landside (LS). Cobble grouted spillway across berm.
 [Additional Reference(s): DWR Levee Log, 1990, (HLM 6.79). USACE San Joaquin O&M Manual 612.1, June 1965, (HLM 6.79), and 612 (addendum), February 1999, (HLM 6.82), (Station 360+08)].

Crown Overview

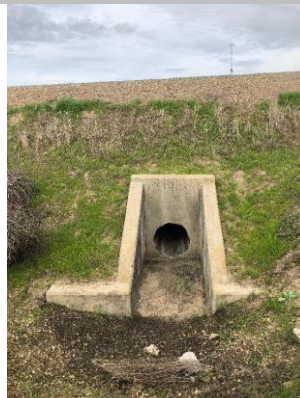
Photo 2 of 3 : UCIP_FA_2022_77492_93154.jpg

LS View: Headwall at LS toe.

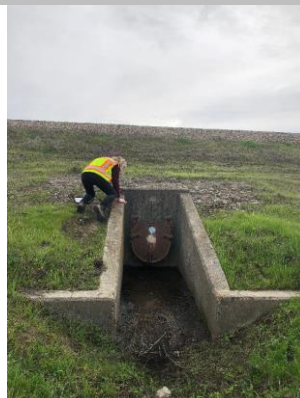
Photo 3 of 3 : UCIP_FA_2022_77492_93157.jpg

WS View: Headwall and flapgate at WS slope.

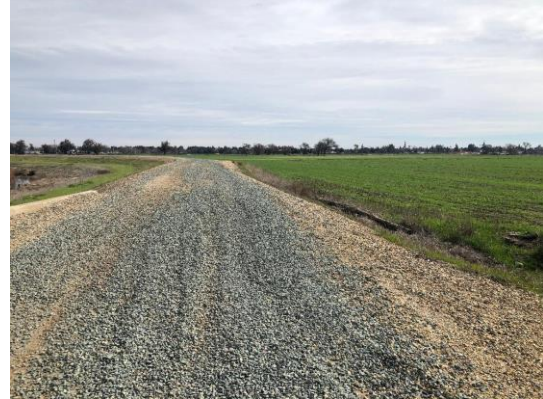
Photo 1 of 3 : UCIP_FA_2022_77494_93140.jpg

Comment Code						
Inspector Comment						
DS_ID:23718 FS_ID:77494 EP_NO: N/A Repair Type: Non-Urgent EVAL Issue: Crossing Status: Found UCIP Comments: 02/18/2021 Record was updated from No Action Needed to Non-Urgent. No permit was found authorizing this encroachment. CVFPB will need to review crossing to determine owner. DWR DMP has not found internal issues, LOF between 1 and 2. Recommend inspection in 5 years. Slight crumbling of concrete around pipe opening on LS. The UCIP inspection was completed with DWR Inspector, S. Donovan, and LMA representative, J. Caruso. (N. Cholewinski - GEI) FIELD_STRUCT_DESC: 24-inch corrugated metal storm drainage pipe (CMP) through the levee, 6.5 feet below the crown. Concrete U-shaped headwalls on both ends. Flap gate on the waterside (WS) end. Grouted intake on the landside (LS). Cobble grouted spillway across the berm. [Additional Reference(s): DWR Levee Log, 1990, (HLM 6.88). USACE San Joaquin O&M Manual 612.1, June 1965, (HLM 6.88), and 612 (addendum), February 1999, (HLM 6.89), (Station 363+76)]. FS Date: 2/18/2021

Crown Overview

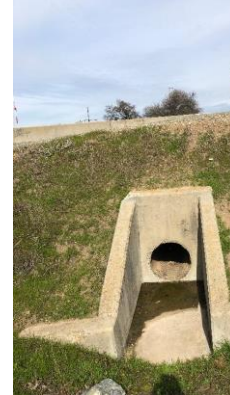
Photo 2 of 3 : UCIP_FA_2022_77494_93142.jpg

LS View: Headwall at LS toe.

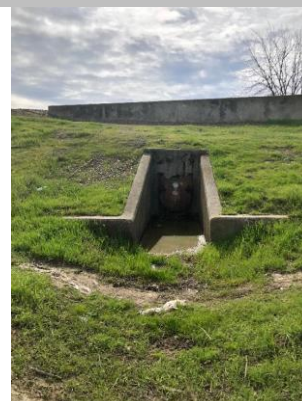
Photo 3 of 3 : UCIP_FA_2022_77494_93145.jpg

WS View: Headwall and flapgate at WS slope.

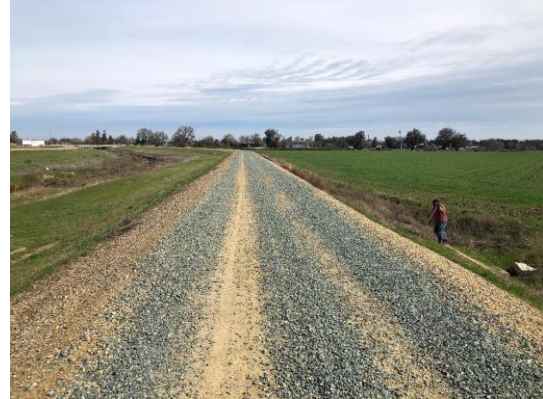
Photo 1 of 3 : UCIP_FA_2022_77496_93130.jpg

Comment Code						
Inspector Comment						
DS_ID:23719 FS_ID:77496 EP_NO: N/A Repair Type: Non-Urgent EVAL Issue: Crossing Status: Found UCIP Comments: 02/18/2021 Record was updated from No Action Needed to Non-Urgent. No permit was found authorizing this encroachment. CVFPB will need to review crossing to determine owner. DWR DMP has not found internal issues, LOF between 1 and 2. Recommend inspection in 5 years. The UCIP inspection was completed with DWR Inspector, S. Donovan, and LMA representative, J. Caruso. (N. Cholewinski - GEI) FIELD_STRUCT_DESC: 1 of 2: 30-inch corrugated metal storm drainage pipe (CMP) through the levee, 8.3 feet below the crown. Concrete U-shaped headwalls on both ends. Flap gate on the waterside (WS) end. Grouted intake on the landside (LS). Cobble grouted spillway across the berm. [Additional Reference(s): DWR Levee Log, 1990, (HLM 7.00). USACE San Joaquin O&M Manual 612.1, June 1965, (HLM 7.00), and 612 (addendum), February 1999, (HLM 7.10), (Station 374+70)]. FS Date: 2/18/2021

Crown Overview

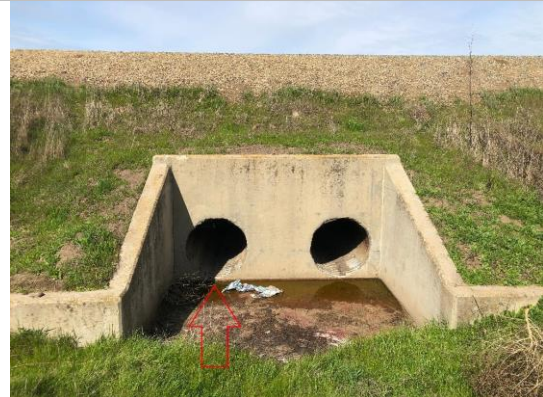
Photo 2 of 3 : UCIP_FA_2022_77496_93132.jpg

LS View: Headwall at LS toe.

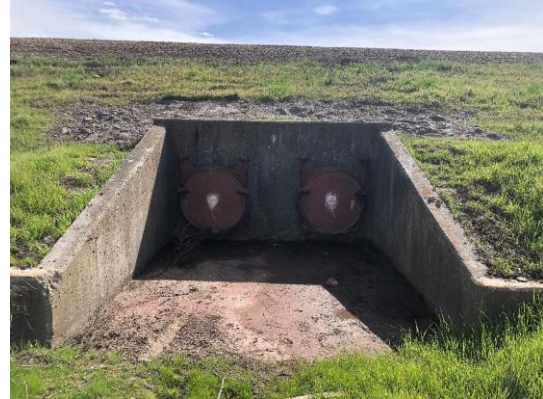
Photo 3 of 3 : UCIP_FA_2022_77496_93135.jpg

WS View: Headwall and flapgate at WS slope.

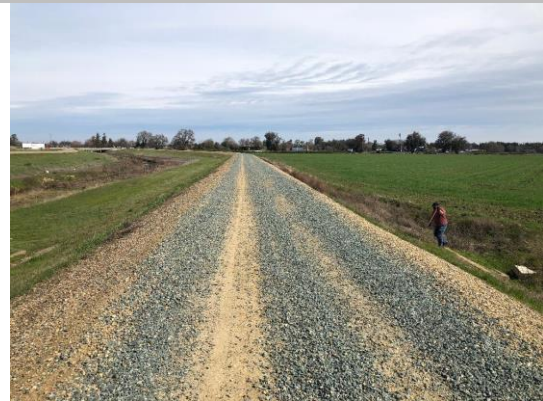
Photo 1 of 3 : UCIP_FA_2022_77497_93123.jpg

DS_ID:23812
 FS_ID:77497
 EP_NO: N/A
 Repair Type: Non-Urgent
 EVAL Issue:
 Crossing Status: Found
 UCIP Comments: 02/18/2021 Record was updated from No Action Needed to Non-Urgent. No permit was found authorizing this encroachment. CVFPB will need to review crossing to determine owner. DWR DMP has not found internal issues, LOF between 1 and 2. Recommend inspection in 5 years. The UCIP inspection was completed with DWR Inspector, S. Donovan, and LMA representative, J. Caruso. (N. Cholewinski - GEI)
 FIELD_STRUCT_DESC: 2 of 2: 30-inch corrugated metal storm drainage pipe (CMP) through the levee, 8.3 feet below the crown. Concrete U-shaped headwalls on both ends. Flap gate on the waterside (WS) end. Grouted intake on the landside (LS). Cobble grouted spillway across the berm. [Additional Reference(s): DWR Levee Log, 1990, (HLM 7.00). USACE San Joaquin O&M Manual 612.1, June 1965, (HLM 7.00), and 612 (addendum), February 1999, (HLM 7.10), (Station 374+70)].

Crown Overview

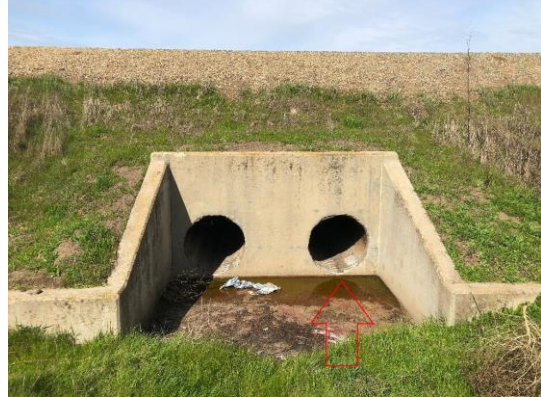
Photo 2 of 3 : UCIP_FA_2022_77497_93125.jpg

LS View: Headwall at LS toe.

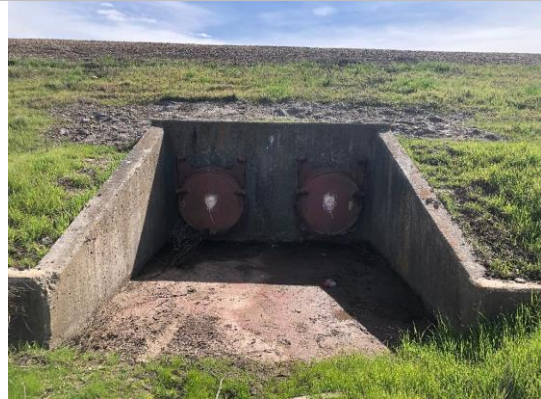
Photo 3 of 3 : UCIP_FA_2022_77497_93128.jpg

WS View: Headwall and flapgate at WS slope.

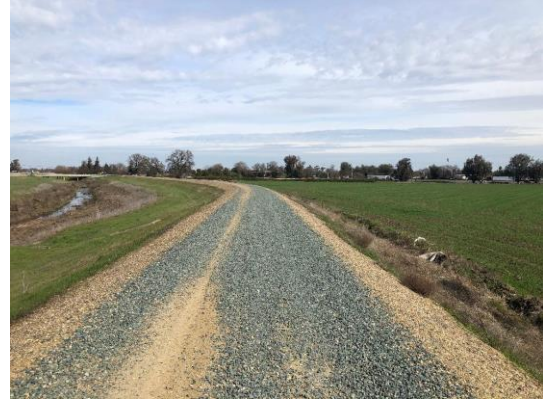
Photo 1 of 3 : UCIP_FA_2022_77498_93117.jpg

Comment Code						
Inspector Comment						
DS_ID:23720 FS_ID:77498 EP_NO: N/A Repair Type: Non-Urgent EVAL Issue: Crossing Status: Found UCIP Comments: 02/18/2021 Record was updated from No Action Needed to Non-Urgent. No permit was found authorizing this encroachment. CVFPB will need to review crossing to determine owner. DWR DMP has not found internal issues, LOF between 1 and 2. Recommend inspection in 5 years. The UCIP inspection was completed with DWR Inspector, S. Donovan, and LMA representative, J. Caruso. (N. Cholewinski - GEI) FIELD_STRUCT_DESC: 36-inch corrugated metal storm drainage pipe (CMP) through the levee, 6.5 feet below the crown. Concrete U-shaped headwalls on both ends. Flap gate on the waterside (WS) end. Grouted intake on the landside (LS). Cobble grouted spillway across the berm. [Additional Reference(s): DWR Levee Log, 1990, (HLM 7.07). USACE San Joaquin O&M Manual 612.1, June 1965, (HLM 7.07), and 612 (addendum), February 1999, (HLM 7.18), (Station 379+00)]. FS Date: 2/18/2021

Crown Overview

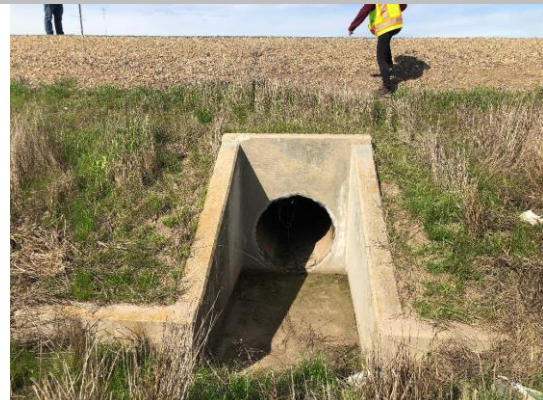
Photo 2 of 3 : UCIP_FA_2022_77498_93119.jpg

LS View: Headwall at LS toe.

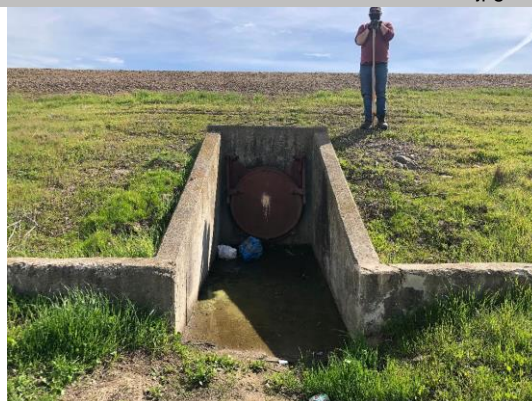
Photo 3 of 3 : UCIP_FA_2022_77498_93122.jpg

WS View: Headwall and flapgate at WS slope.

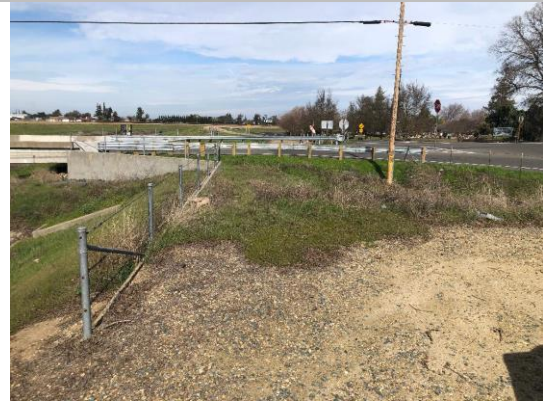
Photo 1 of 3 : UCIP_FA_2022_77499_93109.jpg

Comment Code					
Inspector Comment					
DS_ID:23721 FS_ID:77499 EP_NO: N/A Repair Type: Non-Urgent EVAL Issue: Crossing Status: Found UCIP Comments: 02/18/2021 Record was updated from No Action Needed to Non-Urgent. No permit was found authorizing this encroachment. CVFPB will need to review crossing to determine owner. DWR DMP has not found internal issues, LOF between 1 and 2. Recommend inspection in 5 years. The UCIP inspection was completed with DWR Inspector, S. Donovan, and LMA representative, J. Caruso. (N. Cholewinski - GEI) FIELD_STRUCT_DESC: 36-inch corrugated metal storm drainage pipe (CMP) through the levee, 6.8 feet below the crown. Concrete U-shaped headwalls on both ends. Flap gate on the waterside (WS) end. Grouted intake on the landside (LS). Cobble grouted spillway across the berm. [Additional Reference(s): DWR Levee Log, 1990, (HLM 7.26). USACE San Joaquin O&M Manual 612.1, June 1965, (HLM 7.26), and 612 (addendum), February 1999, (HLM 7.34), (Station 387+80)]. FS Date: 2/18/2021

Crown Overview

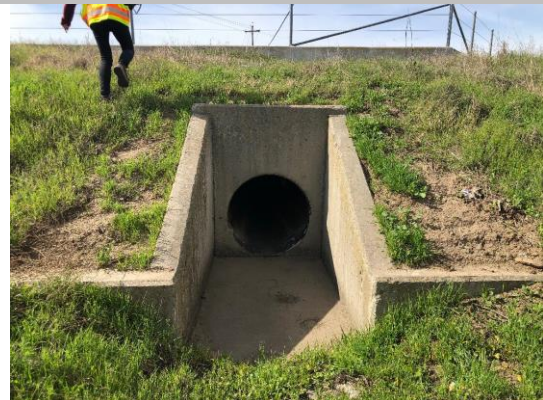
Photo 2 of 3 : UCIP_FA_2022_77499_93111.jpg

LS View: Headwall at LS toe.

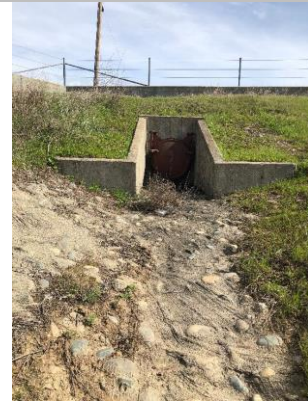
LM Start	0.19	Rating **	M	Issue No.	199
LM End	0.19	Issue Type +	Ma	Location *	
Category	Supplemental			GPS Latitude/Longitude	
				Start	End
Item	DWR UCIP LMA Responsibility			37.874155 °	37.874155 °
				-121.233682 °	-121.233682 °
DWR ID	23992

WS View: Headwall and flapgate at WS slope.

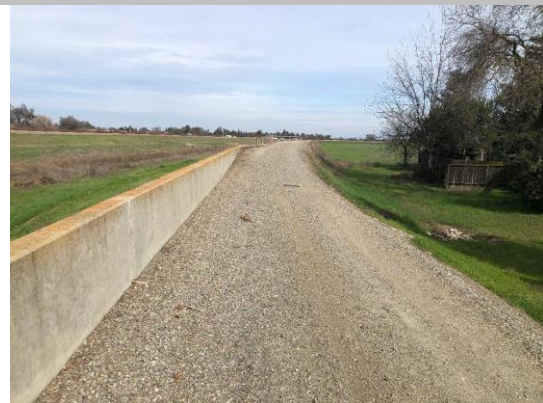
Photo 1 of 3 : UCIP_FA_2022_77504_93087.jpg

DS_ID:23743
 FS_ID:77504
 EP_NO: N/A
 Repair Type: Non-Urgent
 EVAL Issue:
 Crossing Status: Found
 UCIP Comments: 02/18/2021 Record remains Non-Urgent. No permit was found authorizing this encroachment. CVFPB will need to review crossing to determine owner. DWR DMP has not found internal issues, LOF between 1 and 2. Recommend inspection in 5 years. No cobbles observed in pipe at LS toe. The UCIP inspection was completed with DWR Inspector, S. Donovan, and LMA representative, J. Caruso. (N. Cholewinski - GEI)05/21/2014 Cobbles building up at inlet and inside pipe along with sediment. (W. Wylie - DWR UCIP)
 FIELD_STRUCT_DESC: 24-inch corrugated metal storm drainage pipe (CMP) through the levee, 7.0 feet below the crown. Flap gate on the waterside (WS) end. Concrete U-shaped headwalls on both ends. Cobble grouted spillway across the berm. Cobble grouted apron on the landside (LS) end. [Additional Reference(s): DWR Levee Log, 1990, (HLM 7.65). USACE San Joaquin O&M Manual 612.2, 1967, (HLM 7.65), and 612 (addendum), February 1999, (HLM 7.70), (Station 406+58)].

Crown Overview

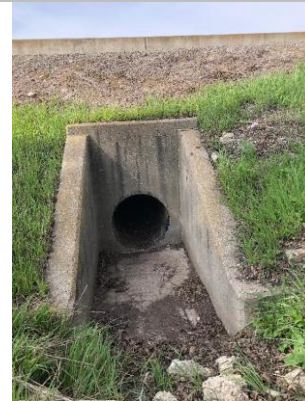
Photo 2 of 3 : UCIP_FA_2022_77504_93089.jpg

LS View: Headwall at LS toe.

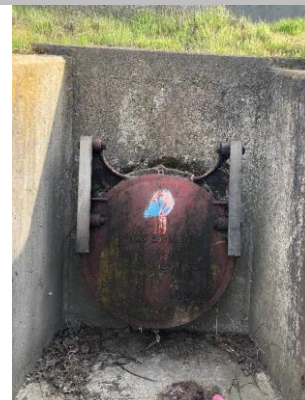
Photo 3 of 3 : UCIP_FA_2022_77504_93092.jpg

WS View: Headwall and 24-inch flapgate at WS slope.

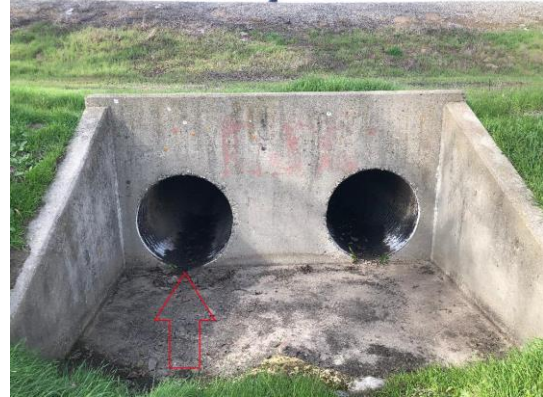
Photo 1 of 3 : UCIP_FA_2022_77573_93080.jpg

Comment Code					
Inspector Comment					
DS_ID:23744 FS_ID:77573 EP_NO: N/A Repair Type: Non-Urgent EVAL Issue: 4b, Safety Issue Crossing Status: Found UCIP Comments: 02/18/2021 Record remains Non-Urgent. No permit was found authorizing this encroachment. CVFPB will need to review crossing to determine owner. DWR DMP has not found internal issues, LOF between 1 and 2. Recommend inspection in 5 years. No lid on riser. Recommend adding lid to riser as a safety measure. The UCIP inspection was completed with DWR Inspector, S. Donovan, and LMA representative, J. Caruso. (N. Cholewinski - GEI)05/21/2014 Lid damaged/missing from CMP riser on WS slope. (W. Wylie - DWR UCIP) FIELD_STRUCT_DESC: 1 of 2: 36-inch corrugated metal storm drainage pipe (CMP) through the levee, 9.0 feet below the crown. Flap gate on the waterside (WS) end. Slide gate inside a 48-inch CMP riser unit on the WS slope. Concrete U-shaped headwalls on both ends. Cobble grouted spillway on the channel bank. Cobble grouted apron in ditch on the landside (LS). [Additional Reference(s): DWR Levee Log, 1990, (HLM 8.18). USACE San Joaquin O&M Manual 612.2, 1967, (HLM 8.18), and 612 (addendum), February 1999, (HLM 8.21), (Station 433+70)]. FS Date: 2/18/2021

LS View: Headwall at LS toe.

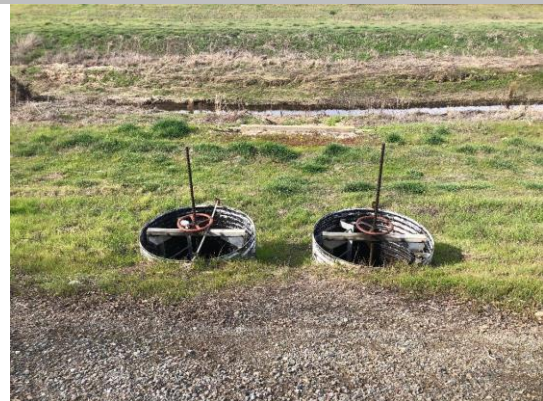
Photo 2 of 3 : UCIP_FA_2022_77573_93082.jpg

WS View: Riser on WS shoulder.

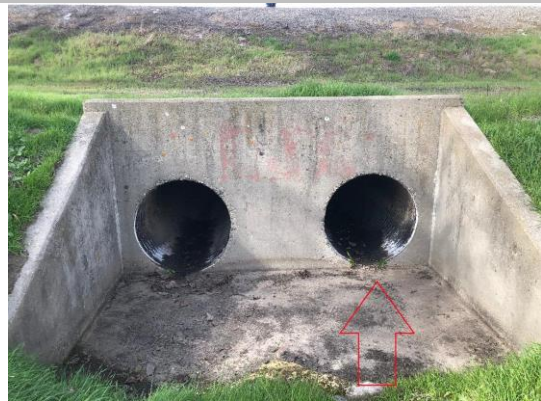
Photo 1 of 3 : UCIP_FA_2022_77506_93071.jpg

DS_ID:23820
FS_ID:77506
EP_NO: N/A
Repair Type: Non-Urgent
EVAL Issue: 4b, Safety Issue
Crossing Status: Found
UCIP Comments: 02/18/2021 Record remains Non-Urgent. No permit was found authorizing this encroachment. CVFPB will need to review crossing to determine owner. DWR DMP has not found internal issues, LOF between 1 and 2. Recommend inspection in 5 years. No lid on riser. Recommend adding lid to riser as a safety measure. The UCIP inspection was completed with DWR Inspector, S. Donovan, and LMA representative, J. Caruso. (N. Cholewinski - GEI)05/21/2014 Lid damaged/missing on 48-inch CMP riser on WS slope. (W. Wylie - DWR UCIP)
FIELD_STRUCT_DESC: 2 of 2: 36-inch corrugated metal storm drainage pipe (CMP) through the levee, 9.0 feet below the crown. Flap gate on the waterside (WS) end. Slide gate inside a 48-inch CMP riser unit on the WS slope. Concrete U-shaped headwalls on both ends. Cobble grouted spillway on the channel bank. Cobble grouted apron in ditch on the landside (LS). [Additional Reference(s): DWR Levee Log, 1990, (HLM 8.18). USACE San Joaquin O&M Manual 612.2, 1967, (HLM 8.18), and 612 (addendum), February 1999, (HLM 8.21), (Station 433+70)].

LS View: Headwall at LS toe.

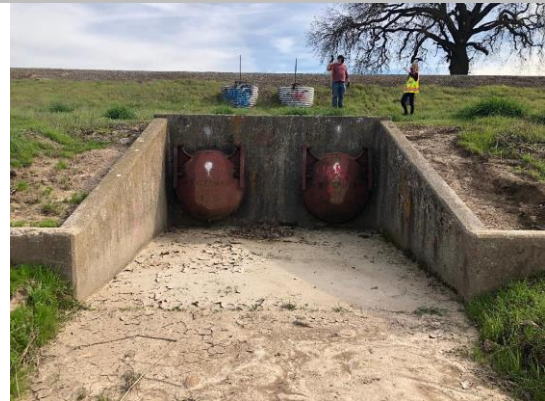
Photo 3 of 3 : UCIP_FA_2022_77506_93076.jpg

WS View: Headwall and 36-inch flapgate at WS toe.

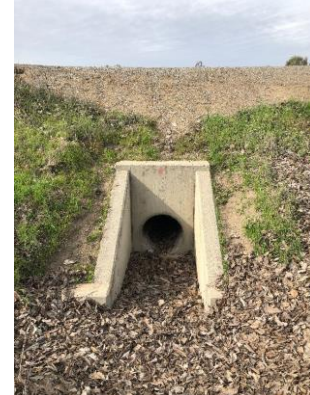
Photo 2 of 3 : UCIP_FA_2022_77507_93056.jpg

LS View: Headwall at LS toe.

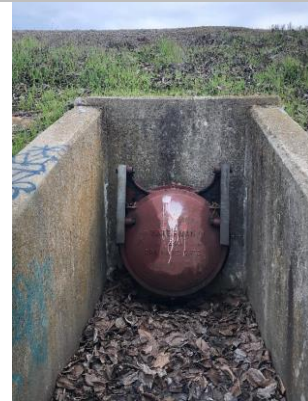
Photo 3 of 3 : UCIP_FA_2022_77507_93062.jpg

WS View: Headwall and 24-inch flapgate at WS slope.

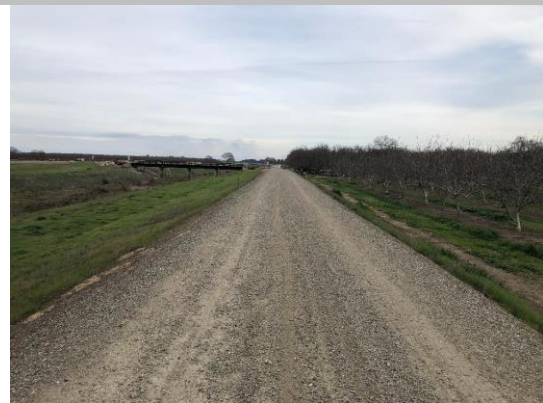
Photo 1 of 3 : UCIP_FA_2022_77508_93044.jpg

Crown Overview

Comment Code					
Inspector Comment					
DS_ID:23746 FS_ID:77508 EP_NO: N/A Repair Type: Non-Urgent EVAL Issue: Crossing Status: Not Found UCIP Comments: 02/22/2021 Record was updated from No Action Needed to Non-Urgent. DWR DMP study found no evidence of pipe at lat/long 38.066918/-121.243749. Pipe not found by visual inspection. No permit was found authorizing this encroachment. CVFPB will need to review crossing to determine owner. The UCIP inspection was completed with DWR Inspector, S. Donovan, and LMA representative, J. Caruso. (N. Cholewinski - GEI) FIELD_STRUCT_DESC: 24-inch corrugated metal storm drainage pipe (CMP) through the levee, 7.0 feet below the crown. Flap gate on the waterside (WS) end. Concrete U-shaped headwalls on both ends. Cobble grouted spillway across the berm. Cobble grouted apron on the landside (LS) end. [Additional Reference(s): DWR Levee Log, 1990, (HLM 8.54). USACE San Joaquin O&M Manual 612.2, 1967, (HLM 8.54), and 612 (addendum), February 1999, (HLM 8.57), (Station 452+52)]. FS Date: 2/18/2021

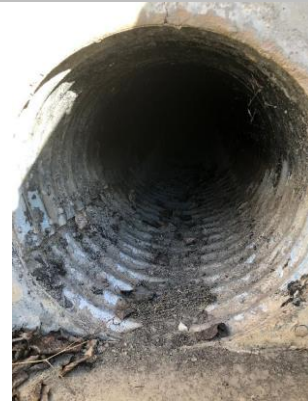
Photo 3 of 3 : UCIP_FA_2022_77510_93026.jpg

LS View: Pipe at LS toe.

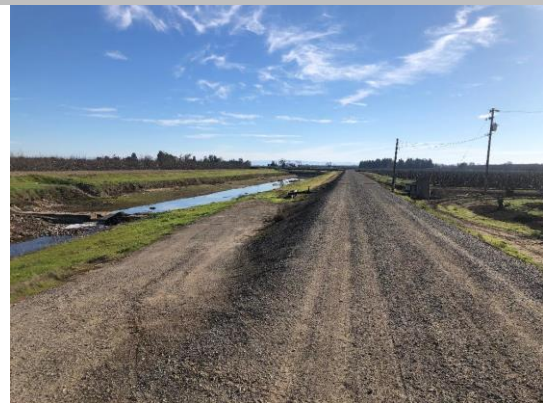
Photo 1 of 3 : UCIP_FA_2022_77514_92901.jpg

DS_ID:23726
 FS_ID:77514
 EP_NO: N/A
 Repair Type: Non-Urgent
 EVAL Issue: 5, Pipe Damage
 Crossing Status: Found
 UCIP Comments: 02/22/2021 Record was updated from No Action Needed to Non-Urgent. DWR DMP has found integrity issues, LOF between 4 and 5. Crossing will be monitored until funding becomes available for rehabilitation. No permit was found authorizing this encroachment. CVFPB will need to review crossing to determine owner. Approximately 7 bullet holes observed in WS flapgate. The UCIP inspection was completed with DWR Inspector, S. Donovan, and LMA representative, J. Caruso. (N. Cholewinski - GEI)
 FIELD_STRUCT_DESC: 24-inch corrugated metal storm drainage pipe (CMP) through the levee, 8.5 feet below the crown. Flap gate on the waterside (WS) end. Concrete U-shaped headwalls on both ends. Cobble grouted spillway across the berm. Cobble grouted apron on the landside (LS) end. [Additional Reference(s): DWR Levee Log, 1990, (HLM 9.76). USACE San Joaquin O&M Manual 612.2, 1967, (HLM 9.85), and 612 (addendum), February 1999, (HLM 9.76), (Station 515+23)].

Crown Overview

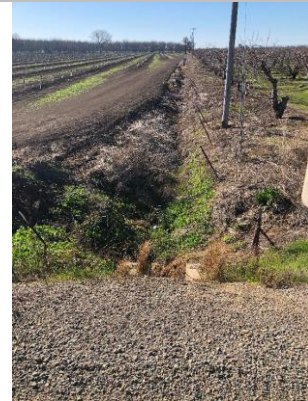
Photo 2 of 3 : UCIP_FA_2022_77514_92902.jpg

LS View: Headwall at LS toe.

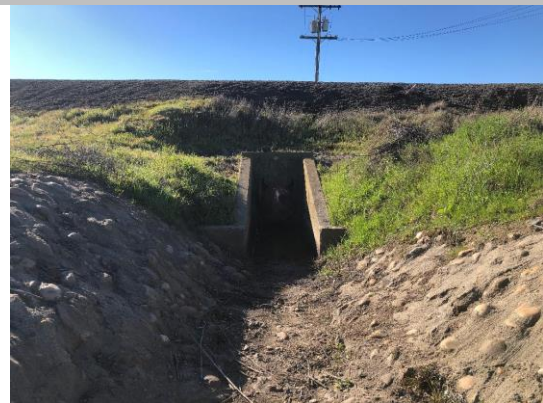
Photo 3 of 3 : UCIP_FA_2022_77514_92913.jpg

WS View: Headwall and flapgate at WS slope.

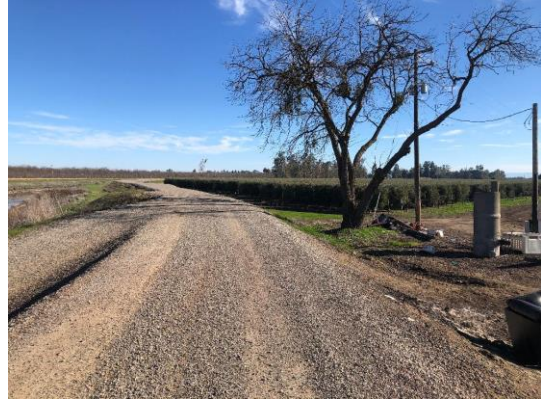
Photo 1 of 3 : UCIP_FA_2022_77515_92888.jpg

Comment Code						
Inspector Comment						
DS_ID:23727 FS_ID:77515 EP_NO: N/A Repair Type: Non-Urgent EVAL Issue: Crossing Status: Found UCIP Comments: 02/22/2021 Pipe status is still Non-Urgent. No permit was found authorizing this encroachment. CVFPB will need to review crossing to determine owner. DWR DMP has not found internal issues, LOF between 1 and 2. Recommend inspection in 5 years. Slope above WS headwall is very steep and eroding. Sediment from erosion observed on top of WS pipe outlet. Sediment build-up has decreased in pipe at LS toe. The UCIP inspection was completed with DWR Inspector, S. Donovan, and LMA representative, J. Caruso. (N. Cholewinski - GEI)05/21/2014 Sediment and debris buildup inside pipe on LS toe. (W. Wylie - DWR UCIP) FIELD_STRUCT_DESC: 24-inch corrugated metal storm drainage pipe (CMP) through the levee, 7.0 feet below the crown. Flap gate on the waterside (WS) end. Concrete U-shaped headwalls on both ends. Cobble grouted spillway across the berm. Cobble grouted apron on the landside (LS) end. [Additional Reference(s): DWR Levee Log, 1990, (HLM 10.01). USACE San Joaquin O&M Manual 612.2, 1967, (HLM 10.09), and 612 (addendum), February 1999, (HLM 10.00), (Station 528+18)]. FS Date: 2/22/2021

Crown Overview

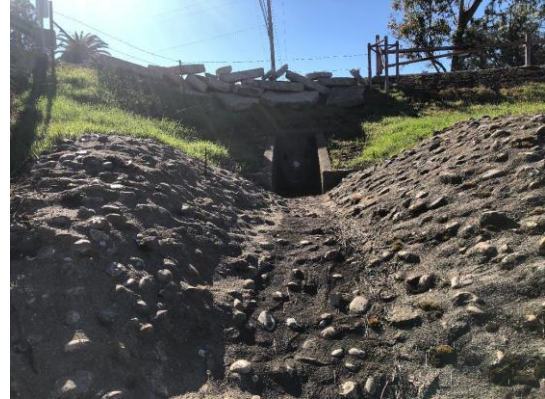
Photo 2 of 3 : UCIP_FA_2022_77516_92871.jpg

WS View: Headwall and flapgate at WS slope.

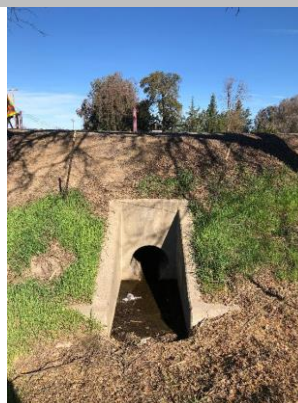
Photo 3 of 3 : UCIP_FA_2022_77518_92831.jpg

LS View: Headwall at LS toe.

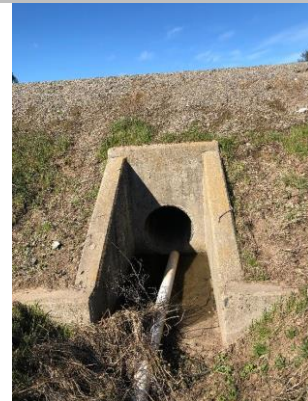
Photo 2 of 3 : UCIP_FA_2022_77519_92812.jpg

LS View: Headwall at LS toe. 4.5-inch PVC pipe discharges at headwall.

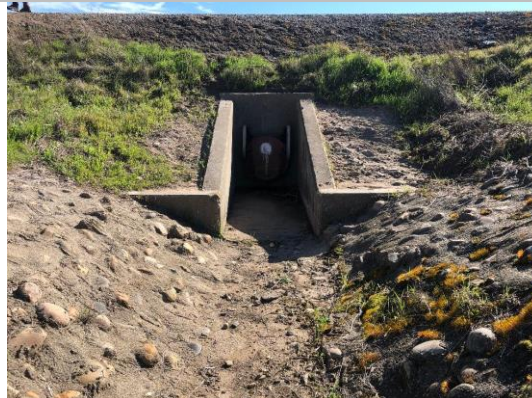
Photo 3 of 3 : UCIP_FA_2022_77519_92819.jpg

WS View: Headwall and flapgate at WS slope.

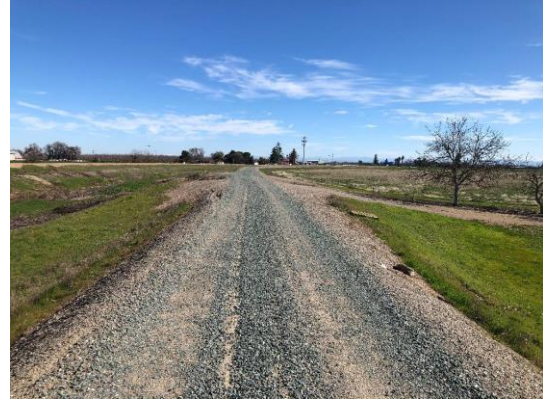
Photo 1 of 3 : UCIP_FA_2022_77520_92787.jpg

Comment Code						
Inspector Comment						
DS_ID:23749 FS_ID:77520 EP_NO: N/A Repair Type: Non-Urgent EVAL Issue: Crossing Status: Found UCIP Comments: 02/22/2021 Pipe status is still Non-Urgent. No permit was found authorizing this encroachment. CVFPB will need to review crossing to determine owner. DWR DMP has not found internal issues, LOF between 1 and 2. Recommend inspection in 5 years. The UCIP inspection was completed with DWR Inspector, S. Donovan, and LMA representative, J. Caruso. (N. Cholewinski - GEI)05/21/2014 Some silt buildup in pipe at LS toe. (W. Wylie - DWR UCIP) FIELD_STRUCT_DESC: 24-inch corrugated metal storm drainage pipe (CMP) through the levee, 8.0 feet below the crown. Flap gate on the waterside (WS) end. Concrete U-shaped headwalls on both ends. Cobble grouted spillway across the berm. Cobble grouted apron on the landside (LS) end. [Additional Reference(s): DWR Levee Log, 1990, (HLM 10.97). USACE San Joaquin O&M Manual 612.2, 1967, (HLM 10.97), and 612 (addendum), February 1999, (HLM 10.94), (Station 577+59)]. FS Date: 2/22/2021

Crown Overview

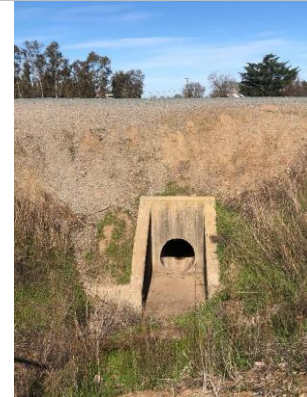
Photo 2 of 3 : UCIP_FA_2022_77520_92789.jpg

LS View: Headwall at LS toe.

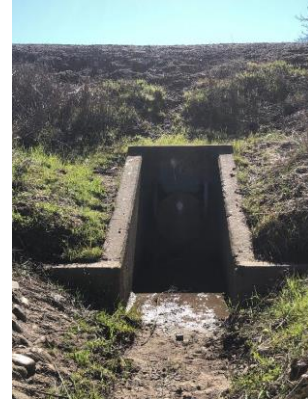
Photo 3 of 3 : UCIP_FA_2022_77520_92799.jpg

WS View: Headwall and flapgate at WS slope.

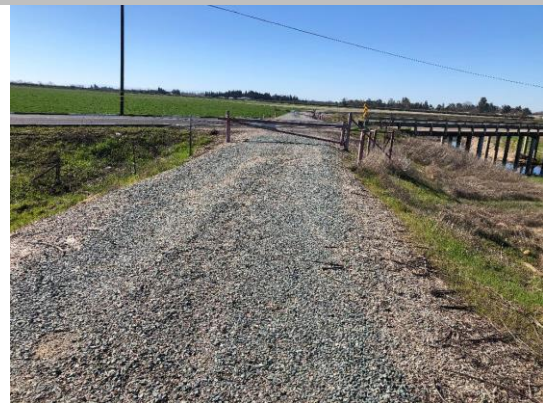
Photo 1 of 3 : UCIP_FA_2022_77521_92755.jpg

DS_ID:23750
 FS_ID:77521
 EP_NO: N/A
 Repair Type: Non-Urgent
 EVAL Issue:
 Crossing Status: Found
 UCIP Comments: 02/22/2021 Record was updated from No Action Needed to Non-Urgent. No permit was found authorizing this encroachment. CVFPB will need to review crossing to determine owner. DWR DMP has not completed an internal inspection of the pipe. The UCIP inspection was completed with DWR Inspector, S. Donovan, and LMA representative, J. Caruso. (N. Cholewinski - GEI)
 FIELD_STRUCT_DESC: 24-inch corrugated metal storm drainage pipe (CMP) through the levee, 7.0 feet below the crown. Flap gate on the waterside (WS) end. Concrete U-shaped headwalls on both ends. Cobble grouted spillway across the berm. Cobble grouted apron on the landside (LS) end. [Additional Reference(s): DWR Levee Log, 1990, (HLM 11.32). USACE San Joaquin O&M Manual 612.2, 1967, (HLM 11.32), and 612 (addendum), February 1999, (HLM 11.28), (Station 595+39)].

Crown Overview

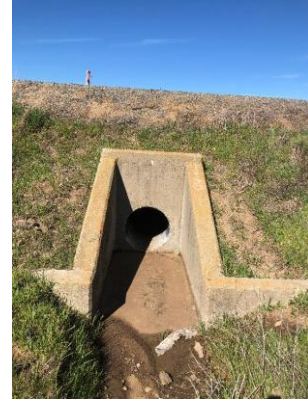
Photo 2 of 3 : UCIP_FA_2022_77521_92764.jpg

LS View: Headwall at LS toe.

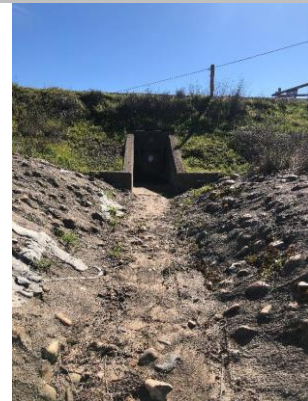
Photo 3 of 3 : UCIP_FA_2022_77521_92768.jpg

WS View: Headwall and flapgate at WS slope.

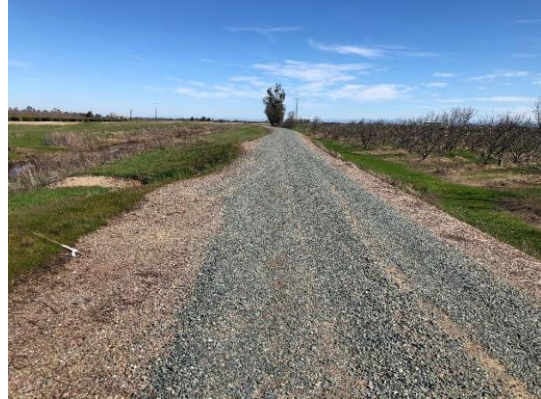
Photo 1 of 3 : UCIP_FA_2022_77522_92742.jpg

Comment Code					
Inspector Comment					
DS_ID:23751 FS_ID:77522 EP_NO: N/A Repair Type: Non-Urgent EVAL Issue: Crossing Status: Found UCIP Comments: 02/22/2021 Record was updated from No Action Needed to Non-Urgent. No permit was found authorizing this encroachment. CVFPB will need to review crossing to determine owner. DWR DMP has not found internal issues, LOF between 1 and 2. Recommend inspection in 5 years. The UCIP inspection was completed with DWR Inspector, S. Donovan, and LMA representative, J. Caruso. (N. Cholewinski - GEI) FIELD_STRUCT_DESC: 36-inch corrugated metal storm drainage pipe (CMP) through the levee, 7.5 feet below the crown. Flap gate on the waterside (WS) end. Concrete U-shaped headwalls on both ends. Cobble grouted spillway across the berm. Cobble grouted apron on the landside (LS) end. [Additional Reference(s): DWR Levee Log, 1990, (HLM 11.37). USACE San Joaquin O&M Manual 612.2, 1967, (HLM 11.37), and 612 (addendum), February 1999, (HLM 11.32), (Station 597+78)]. FS Date: 2/22/2021

Crown Overview

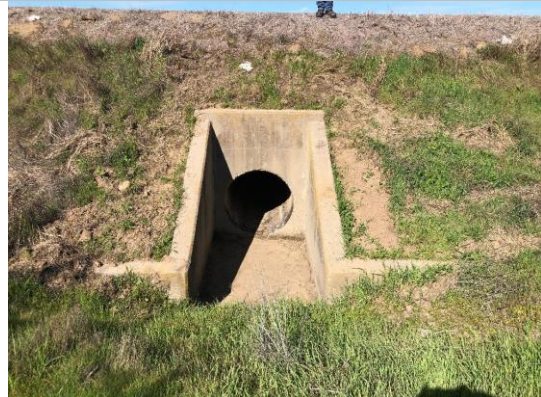
Photo 2 of 3 : UCIP_FA_2022_77522_92744.jpg

LS View: Headwall at LS toe.

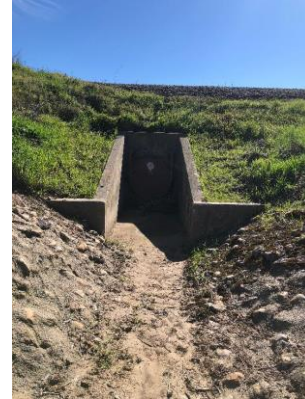
Photo 3 of 3 : UCIP_FA_2022_77522_92748.jpg

WS View: Headwall and flapgate at WS slope.

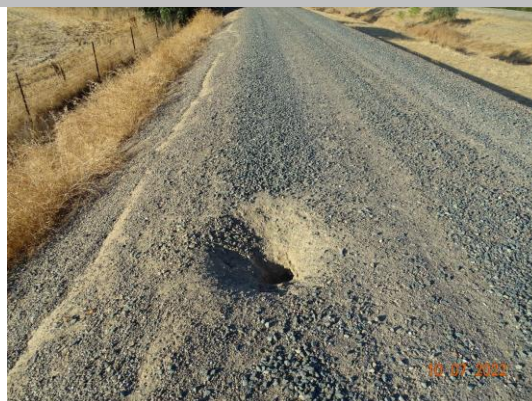
Photo 1 of 1 : FA_2022_NA0017_152_171_20221025_00401.jpg

LM Start	11.20	Rating **	M	Issue No.	171
LM End	11.22	Issue Type +	Ma	Location *	LS
Category	Earthen Levee			GPS Latitude/Longitude	
				Start	End
Item	Animal Control			38.082343 °	38.082538 °
				-121.197918 °	-121.197650 °
DWR ID	DWR_NA0017_08_s_2021_171				
Comment Code					
A3 : No rodents visible, but rodent burrows visible; need to backfill and compact or grout burrows.					
Inspector Comment

View of large animal burrow near the landside shoulder. Fall 2022

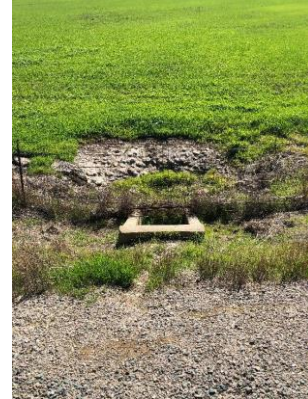
Photo 1 of 3 : UCIP_FA_2022_77524_92695.jpg

Comment Code					
Inspector Comment					
DS_ID:23752 FS_ID:77524 EP_NO: N/A Repair Type: Non-Urgent EVAL Issue: Crossing Status: Found UCIP Comments: 02/22/2021 Record was updated from No Action Needed to Non-Urgent. No permit was found authorizing this encroachment. CVFPB will need to review crossing to determine owner. DWR DMP has not found internal issues, LOF between 1 and 2. Recommend inspection in 5 years. The UCIP inspection was completed with DWR Inspector, S. Donovan, and LMA representative, J. Caruso. (N. Cholewinski - GEI) FIELD_STRUCT_DESC: 24-inch corrugated metal storm drainage pipe (CMP) through the levee, 9.5 feet below the crown. Flap gate on the waterside (WS) end. Concrete U-shaped headwalls on both ends. Cobble grouted spillway across the berm. Cobble grouted apron on the landside (LS) end. [Additional Reference(s): DWR Levee Log, 1990, (HLM 11.59). USACE San Joaquin O&M Manual 612.2, 1967, (HLM 11.59), and 612 (addendum), February 1999, (HLM 11.60), (Station 612+48)]. FS Date: 2/22/2021

LS View: Headwall at LS toe.

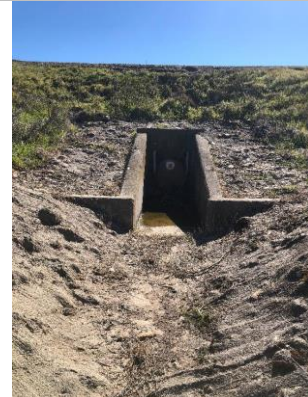
Photo 2 of 3 : UCIP_FA_2022_77524_92699.jpg

WS View: Headwall and flapgate at WS slope.

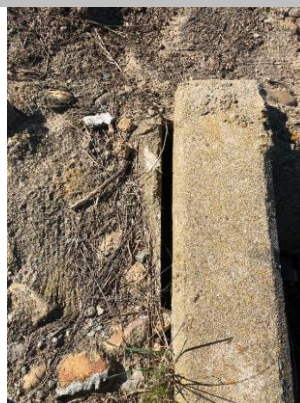
Photo 3 of 3 : UCIP_FA_2022_77524_92700.jpg

WS View: 1.5-inch gap observed between headwall and apron at WS slope.

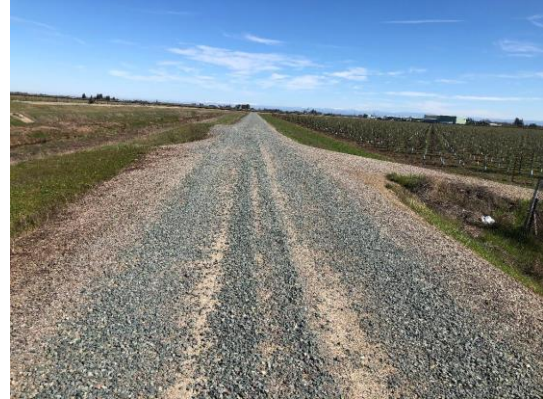
Photo 1 of 3 : UCIP_FA_2022_77525_92687.jpg

Comment Code						
Inspector Comment						
DS_ID:23753 FS_ID:77525 EP_NO: N/A Repair Type: Non-Urgent EVAL Issue: Crossing Status: Found UCIP Comments: 02/22/2021 Record was updated from No Action Needed to Non-Urgent. No permit was found authorizing this encroachment. CVFPB will need to review crossing to determine owner. DWR DMP has not found internal issues, LOF between 1 and 2. Recommend inspection in 5 years. The UCIP inspection was completed with DWR Inspector, S. Donovan, and LMA representative, J. Caruso. (N. Cholewinski - GEI)04/26/2017 Rodent activity is already accounted for via DWR FPIIB inspections. As per inspection chief G. Wylie, crossing has been downgraded from Non-Urgent to No Action Needed, as pipe integrity itself is not in question. (K. Fazel - UCIP)05/21/2014 Rodent activity at LS shoulder. (G. Wylie - FPIIB) FIELD_STRUCT_DESC: 24-inch corrugated metal storm drainage pipe (CMP) through the levee, 7.5 feet below the crown. Flap gate on the waterside (WS) end. Concrete U-shaped headwalls on both slopes. Cobble grouted spillway on the WS slope. [Additional Reference(s): DWR Levee Log, 1990, (HLM 11.65). USACE San Joaquin O&M Manual 612.2, 1967, (HLM 11.65), and 612 (addendum), February 1999, (HLM 11.99), (Station 633+20)]. FS Date: 2/22/2021

Crown Overview

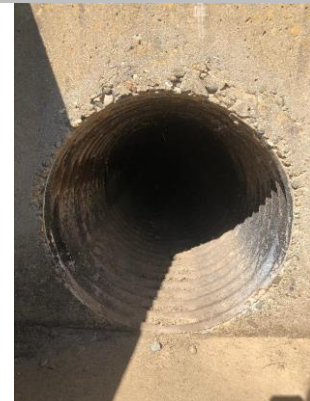
Photo 2 of 3 : UCIP_FA_2022_77525_92690.jpg

LS View: Pipe at LS toe.

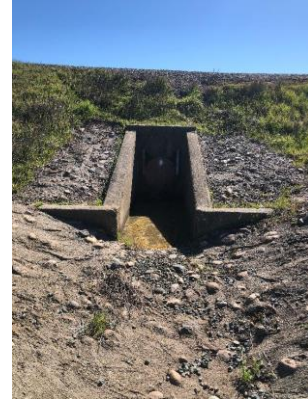
Photo 3 of 3 : UCIP_FA_2022_77525_92692.jpg

WS View: Headwall and flapgate at WS slope.

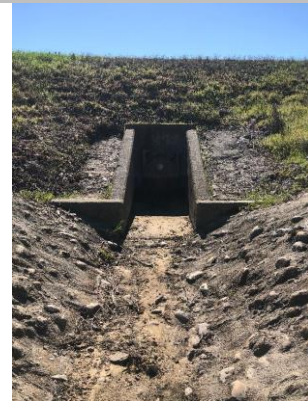
Photo 3 of 3 : UCIP_FA_2022_77526_92685.jpg

WS View: Headwall and flapgate at WS slope.

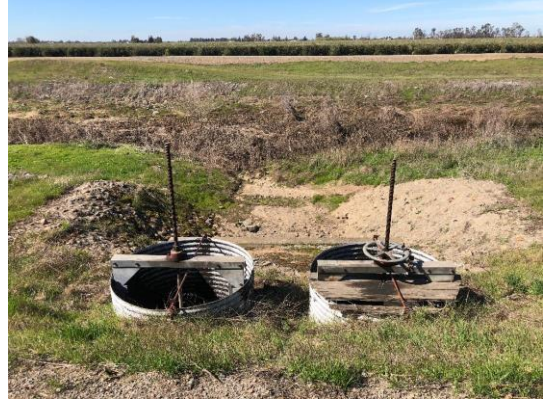
Photo 3 of 3 : UCIP_FA_2022_77529_92667.jpg

Comment Code					
Inspector Comment					
DS_ID:23756 FS_ID:77529 EP_NO: N/A Repair Type: Non-Urgent EVAL Issue: 4b, Safety Issue Crossing Status: Found UCIP Comments: 02/22/2021 Pipe status is still Non-Urgent. No permit was found authorizing this encroachment. CVFPB will need to review crossing to determine owner. DWR DMP has not found internal issues, LOF between 1 and 2. Recommend inspection in 5 years. Riser lid damage. Recommend adding lid to riser as a safety measure. The UCIP inspection was completed with DWR Inspector, S. Donovan, and LMA representative, J. Caruso. (N. Cholewinski - GEI)05/21/2014 CMP riser missing cover on WS slope. (W. Wylie - DWR UCIP) FIELD_STRUCT_DESC: 1 of 2: 48-inch corrugated metal storm drainage pipe (CMP) through the levee, 8.5 feet below the crown. Slide gate inside a 60-inch CMP riser unit on the waterside (WS) slope. Concrete U-shaped headwalls on both ends. Cobble grouted spillway on the WS end. Cobble grouted apron on the landside (LS) end. [Additional Reference(s): DWR Levee Log, 1990, (HLM 12.20). USACE San Joaquin O&M Manual 612.2, 1967, (HLM 12.20), and 612 (addendum), February 1999, (HLM 12.13), (Station 640+50)]. FS Date: 2/22/2021

WS View: Riser at WS shoulder.

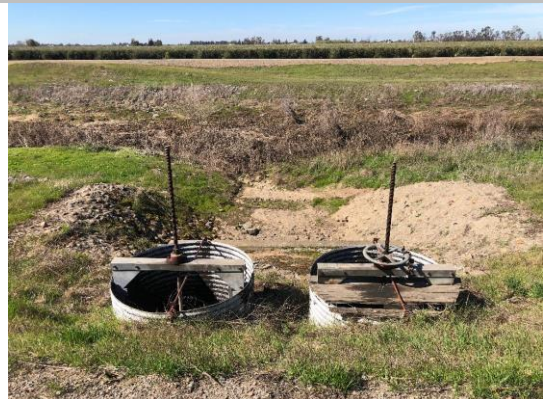
Photo 1 of 3 : UCIP_FA_2022_77530_92656.jpg

DS_ID:23818
 FS_ID:77530
 EP_NO: N/A
 Repair Type: Non-Urgent
 EVAL Issue: 4b, Safety Issue
 Crossing Status: Found
 UCIP Comments: 02/22/2021 Pipe status is still Non-Urgent. No permit was found authorizing this encroachment. CVFPB will need to review crossing to determine owner. DWR DMP has not found internal issues, LOF between 1 and 2. Recommend inspection in 5 years. Riser lid missing. Recommend adding riser lid for safety reasons. The UCIP inspection was completed with DWR Inspector, S. Donovan, and LMA representative, J. Caruso. (N. Cholewinski - GEI)05/21/2014 CMP riser missing cover on WS slope may be hazard. (W. Wylie - DWR UCIP)
 FIELD_STRUCT_DESC: 2 of 2: 48-inch corrugated metal storm drainage pipe (CMP) through the levee, 8.5 feet below the crown. Slide gate inside a 60-inch CMP riser unit on the waterside (WS) slope. Concrete U-shaped headwalls on both ends. Cobble grouted spillway on the WS end. Cobble grouted apron on the landside (LS) end.

WS View: Riser at WS Shoulder. Partly covered with wood boards.
 Headwall and flapgate at WS toe.

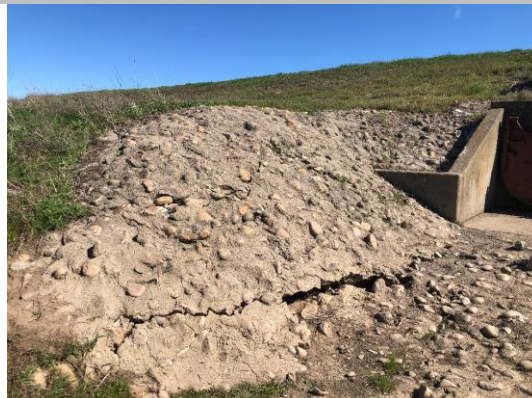
Photo 2 of 3 : UCIP_FA_2022_77530_92658.jpg

WS View: Crack observed in apron at WS toe.

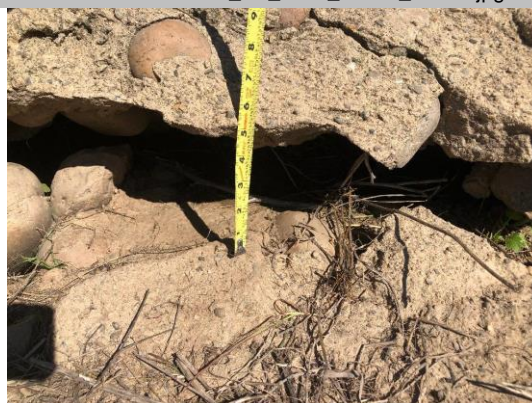
Photo 3 of 3 : UCIP_FA_2022_77530_92659.jpg

WS View: Crack observed in apron at WS toe.

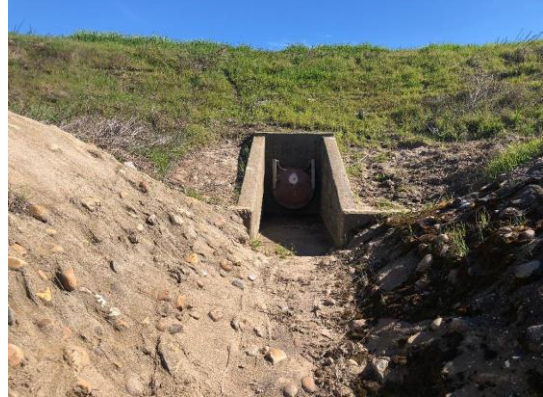
Photo 3 of 3 : UCIP_FA_2022_77531_92648.jpg

WS View: Headwall and flapgate at WS slope.

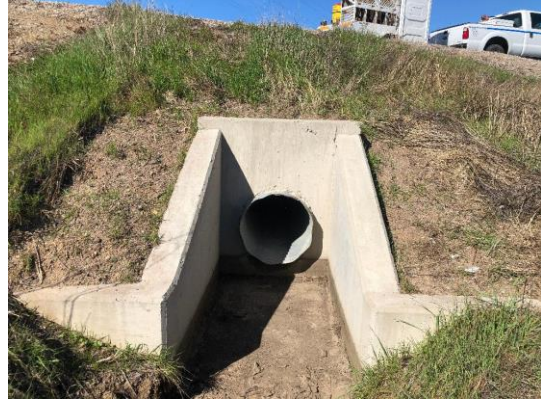
Photo 1 of 3 : UCIP_FA_2022_77533_92629.jpg

Comment Code					
Inspector Comment					
DS_ID:23761 FS_ID:77533 EP_NO: N/A Repair Type: Urgent EVAL Issue: 1, Pipe Integrity Crossing Status: Found UCIP Comments: 02/22/2021 Record was updated from No Action Needed to Urgent. DWR DMP has found integrity issues, LOF between 5 and 6. Crossing will be monitored until funding becomes available for removal. No permit was found authorizing this encroachment. There appears to be a gap between the headwall and concrete apron. Recommend monitoring the gap to determine if it is associated with undermining occurring. CVFPB will need to review crossing to determine owner. The UCIP inspection was completed with LMA representative, J. Caruso. (N. Cholewinski - GEI) FIELD_STRUCT_DESC: 24-inch corrugated metal storm drainage pipe (CMP) through the levee, 7.5 feet below the crown. Flap gate on the waterside (WS) end. Concrete U-shaped headwalls on both ends. Cobble grouted spillway across the berm. Cobble grouted apron on the landside (LS) end. [Additional Reference(s): DWR Levee Log, 1990, (HLM 12.78). USACE San Joaquin O&M Manual 612.2, 1967, (HLM 12.78), and 612 (addendum), February 1999, (HLM 12.70), (Station 670+43)]. FS Date: 2/22/2021

LS View: Headwall at LS toe.

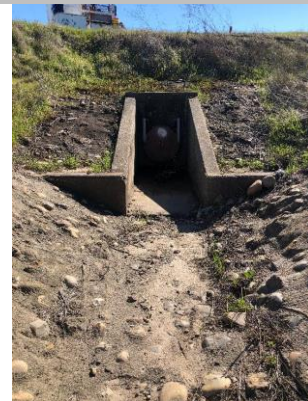
Photo 2 of 3 : UCIP_FA_2022_77533_92633.jpg

WS View: Headwall and flapgate at WS slope.

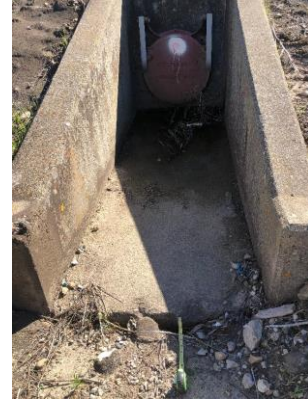
Photo 3 of 3 : UCIP_FA_2022_77533_92634.jpg

WS View: Headwall and flapgate at WS slope. Gap visible between headwall and apron.

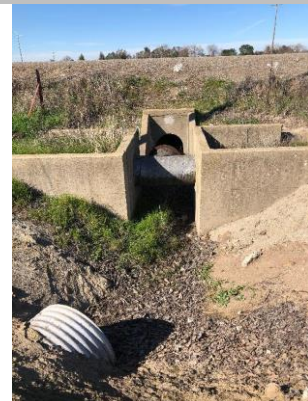
Photo 1 of 3 : UCIP_FA_2022_77536_92608.jpg

DS_ID:23764
 FS_ID:77536
 EP_NO: N/A
 Repair Type: Non-Urgent
 EVAL Issue:
 Crossing Status: Found
 UCIP Comments: 02/22/2021 Record was updated from No Action Needed to Non-Urgent. No permit was found authorizing this encroachment. CVFPB will need to review crossing to determine owner. DWR DMP has not found internal issues, LOF between 1 and 2. Recommend inspection in 5 years. The UCIP inspection was completed with LMA representative, J. Caruso. (N. Cholewinski – GEI)
 FIELD_STRUCT_DESC: 36-inch corrugated metal storm drainage pipe (CMP) through the levee, 9.0 feet below the crown. Flap gate on the waterside (WS) end. Concrete U-shaped headwalls on both ends. Cobble grouted spillway on the WS end. Cobble grouted apron on the landside (LS) end. [Additional Reference(s): DWR Levee Log, 1990, (HLM 12.94). USACE San Joaquin O&M Manual 612.2, 1967, (HLM 12.94), and 612 (addendum), February 1999, (HLM 12.86), (Station 678+88)].

LS View: Abandoned irrigation structure at LS toe.

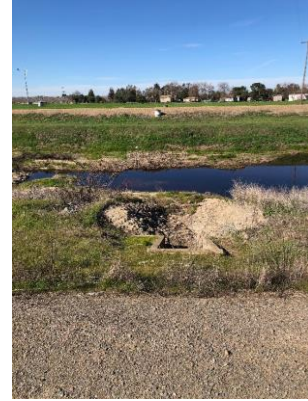
Photo 2 of 3 : UCIP_FA_2022_77536_92611.jpg

WS View: Headwall and flapgate at WS slope.

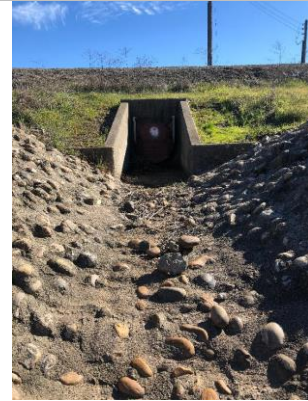
Photo 3 of 3 : UCIP_FA_2022_77536_92612.jpg

WS View: Headwall and flapgate at WS slope.

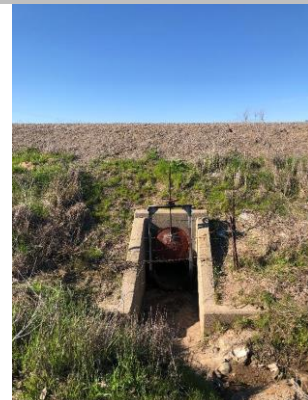
Photo 2 of 3 : UCIP_FA_2022_77537_92600.jpg

LS View: Headwall and slide gate at LS toe.
