**Flood Control Project Maintenance
Levee Inspections**

Maintenance Issue Types Only, Levee Inspection Report By Mile - Fall 2022

San Joaquin County Flood Control and Water Conservation District

Waterway	Bank	Unit Miles	Inspection Start/End	Inspector
Unit No. 01 Littlejohn Creek	Left	2.59	10/13/2022 10/13/2022	Alberto De Leon

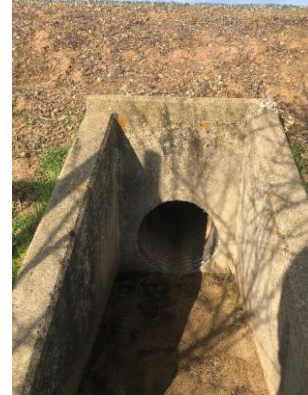
Photo 1 of 2 : UCIP_FA_2022_77539_92583.jpg

Comment Code					
Inspector Comment					
DS_ID:23767 FS_ID:77539 EP_NO: N/A Repair Type: Non-Urgent EVAL Issue: Crossing Status: Found UCIP Comments: 02/23/2021 Record was updated from No Action Needed to Non-Urgent. No permit was found authorizing this encroachment. CVFPB will need to review crossing to determine owner. DWR DMP has not found internal issues, LOF between 1 and 2. Recommend inspection in 5 years. The UCIP inspection was completed with LMA representative, J. Caruso. (N. Cholewinski – GEI) FIELD_STRUCT_DESC: 24-inch corrugated metal storm drainage pipe (CMP) through the levee, 7.0 feet below the crown. Flap gate on the waterside (WS) end. Concrete U-shaped headwalls on both ends. Cobble grouted spillway on the WS end. Cobble grouted intake on the landside (LS). [Additional Reference(s): DWR Levee Log, 1990, (HLM 13.26). USACE San Joaquin O&M Manual 612.2, 1967, (HLM 13.26)]. FS Date: 2/23/2021

LS View: Headwall at LS toe.

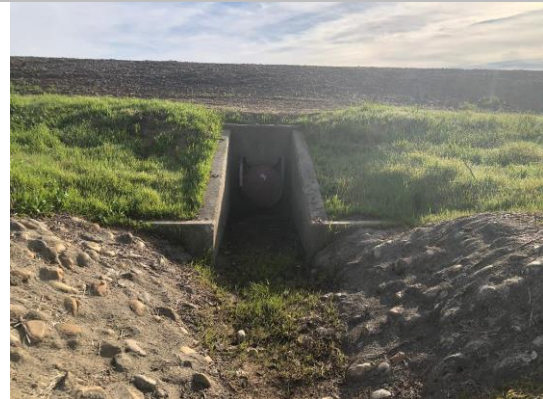
Photo 2 of 2 : UCIP_FA_2022_77539_92586.jpg

WS View: Headwall and flapgate at WS slope.

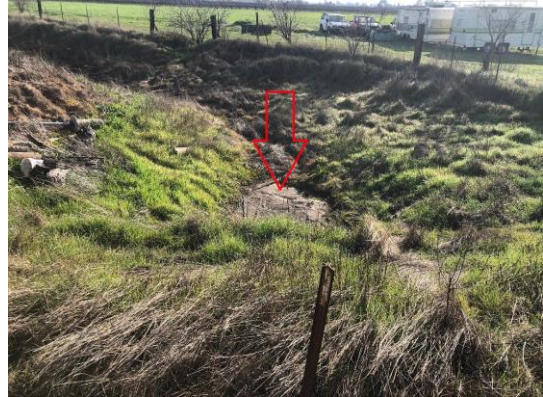
Photo 1 of 3 : UCIP_FA_2022_77574_92575.jpg

Comment Code					
Inspector Comment					
DS_ID:23768 FS_ID:77574 EP_NO: N/A Repair Type: Non-Urgent EVAL Issue: 4b, Safety Issue Crossing Status: Found UCIP Comments: 02/23/2021 Pipe status is still Non-Urgent. No permit was found authorizing this encroachment. CVFPB will need to review crossing to determine owner. DWR DMP has not found internal issues, LOF between 1 and 2. Recommend inspection in 5 years. LS not accessible due to barbed cattle fencing. Riser lid missing. Recommend adding lid to riser as a safety measure. The UCIP inspection was completed with LMA representative, J. Caruso. (N. Cholewinski – GEI)05/21/2014 Some debris buildup at inlet. No lid on CMP riser on WS slope. (W. Wylie - DWR DMP) FIELD_STRUCT_DESC: 1 of 2: 36-inch corrugated metal storm drainage pipe (CMP) through the levee, 10.0 feet below the crown. Concrete U-shaped headwalls on both ends. Slide gate inside a CMP riser unit on the waterside (WS) slope. Flap gate on the WS end. [Additional Reference(s): DWR Levee Log, 1990, (HLM 13.35). USACE San Joaquin O&M Manual 612.2, 1967, (HLM 13.35)]. FS Date: 2/23/2021

LS View: Pipe at LS toe with cattle fencing around opening.

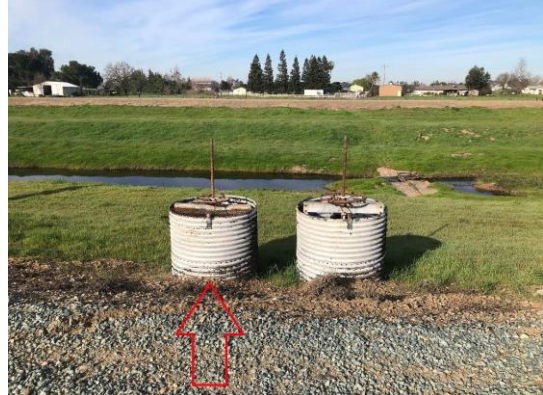
Photo 2 of 3 : UCIP_FA_2022_77574_92580.jpg

WS View: Riser on WS shoulder.

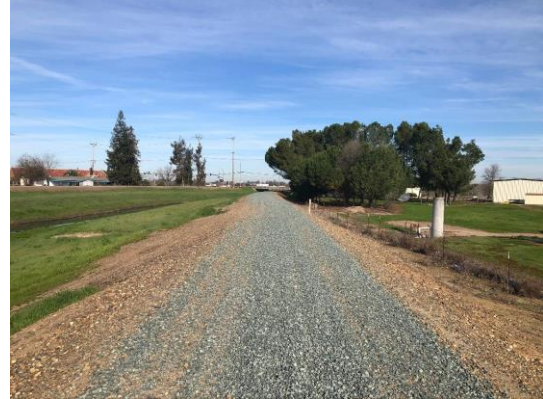
Photo 1 of 3 : UCIP_FA_2022_77542_92560.jpg

Comment Code					
Inspector Comment					
DS_ID:23769 FS_ID:77542 EP_NO: N/A Repair Type: Non-Urgent EVAL Issue: Crossing Status: Found UCIP Comments: 02/23/2021 Record was updated from No Action Needed to Non-Urgent. No permit was found authorizing this encroachment. CVFPB will need to review crossing to determine owner. DWR DMP has not found internal issues, LOF between 1 and 2. Recommend inspection in 5 years. Standpipe, 24-inch OD, located landward of LS toe is discharging at storm drain inlet at LS toe. The UCIP inspection was completed with LMA representative, J. Caruso. (N. Cholewinski – GEI) FIELD_STRUCT_DESC: 24-inch corrugated metal storm drainage pipe (CMP) through the levee, 8.0 feet below the crown. Flap gate on the waterside (WS) end. Concrete U-shaped headwalls on both ends. Cobble grouted spillway on the WS end. Cobble grouted intake on the landside (LS). [Additional Reference(s): DWR Levee Log, 1990, (HLM 13.50). USACE San Joaquin O&M Manual 612.2, 1967, (HLM 13.50)]. FS Date: 2/23/2021

Crown Overview

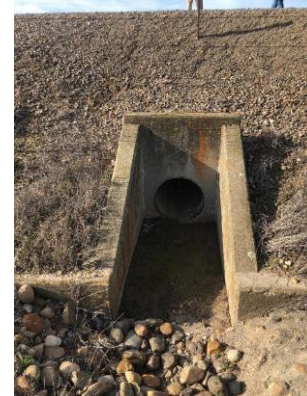
Photo 2 of 3 : UCIP_FA_2022_77542_92562.jpg

LS View: Headwall at LS toe.

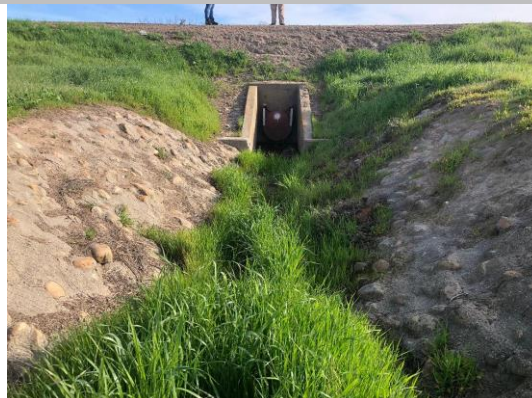
Photo 3 of 3 : UCIP_FA_2022_77542_92565.jpg

WS View: Headwall and flapgate at WS slope.

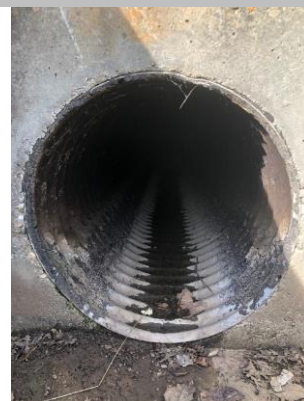
Photo 1 of 2 : UCIP_FA_2022_77544_92552.jpg

Comment Code					
Inspector Comment					
DS_ID:23770 FS_ID:77544 EP_NO: N/A Repair Type: Non-Urgent EVAL Issue: 5, Pipe Damage Crossing Status: Found UCIP Comments: 02/23/2021 Record was updated from No Action Needed to Non-Urgent. DWR DMP has found integrity issues, LOF between 4 and 5. Crossing will be monitored until funding becomes available for rehabilitation. No permit was found authorizing this encroachment. CVFPB will need to review crossing to determine owner. Slight weathering of interior pipe coating observed. The UCIP inspection was completed with LMA representative, J. Caruso. (N. Cholewinski - GEI) FIELD_STRUCT_DESC: 24-inch corrugated metal storm drainage pipe (CMP) through the levee, 6.0 feet below the crown. Flap gate on the waterside (WS) end. Concrete U-shaped headwalls on both ends. Cobble grouted spillway on the WS end. Cobble grouted intake on the landside (LS). [Additional Reference(s): DWR Levee Log, 1990, (HLM 13.60). USACE San Joaquin O&M Manual 612.2, 1967, (HLM 13.60)]. FS Date: 2/23/2021

LS View: Pipe at LS toe.

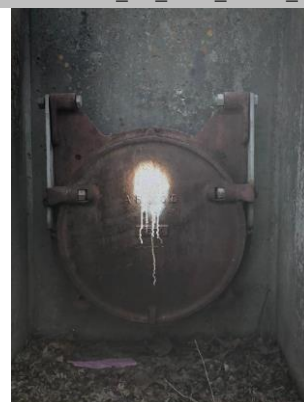
Photo 2 of 2 : UCIP_FA_2022_77544_92555.jpg

WS View: Flapgate at WS slope.

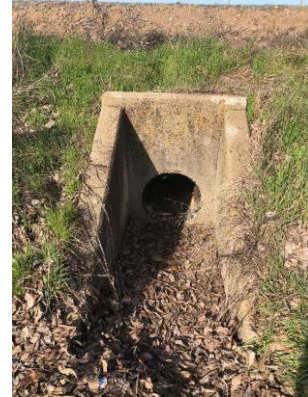
Photo 1 of 2 : UCIP_FA_2022_77545_92534.jpg

Comment Code						
Inspector Comment						
DS_ID:23771 FS_ID:77545 EP_NO: N/A Repair Type: Non-Urgent EVAL Issue: Crossing Status: Found UCIP Comments: 02/23/2021 Record was updated from No Action Needed to Non-Urgent. No permit was found authorizing this encroachment. CVFPB will need to review crossing to determine owner. DWR DMP has not found internal issues, LOF between 1 and 2. Recommend inspection in 5 years. Leaf vegetation build-up present at LS toe. The UCIP inspection was completed with LMA representative, J. Caruso. (N. Cholewinski – GEI) FIELD_STRUCT_DESC: 24-inch corrugated metal storm drainage pipe (CMP) through the levee, 6.0 feet below the crown. Flap gate on the waterside (WS) end. Concrete U-shaped headwalls on both ends. Cobble grouted spillway on the WS end. Cobble grouted intake on the landside (LS). [Additional Reference(s): DWR Levee Log, 1990, (HLM 13.81). USACE San Joaquin O&M Manual 612.2, 1967, (HLM 13.81)]. FS Date: 2/23/2021

LS View: Headwall at LS toe.

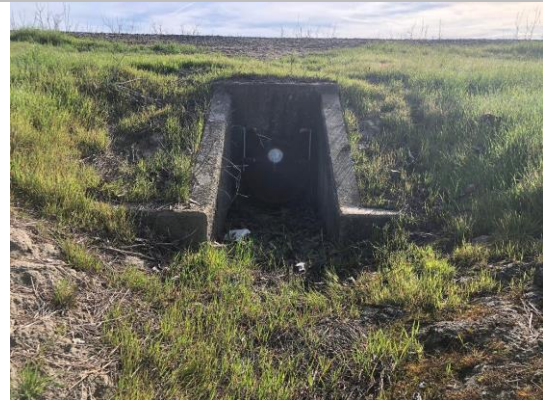
Photo 2 of 2 : UCIP_FA_2022_77545_92537.jpg

WS View: Headwall and flapgate at WS slope.

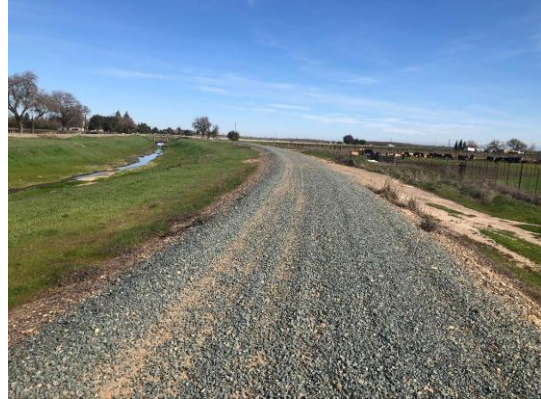
Photo 1 of 3 : UCIP_FA_2022_77547_92517.jpg

Comment Code						
Inspector Comment						
DS_ID:23773 FS_ID:77547 EP_NO: N/A Repair Type: Urgent EVAL Issue: 1, Pipe Integrity Crossing Status: Found UCIP Comments: 02/23/2021 Record was updated from No Action Needed to Urgent. DWR DMP has found integrity issues, LOF between 5 and 6. Crossing will be monitored until funding becomes available for removal. No permit was found authorizing this encroachment. CVFPB will need to review crossing to determine owner. Slight offset, <1-inch, observed within interior of pipe at approximately 10 feet inside pipe from LS pipe opening. Small gap, approximately 1/4-inch, present at base of pipe along exterior of pipe opening at LS toe. The UCIP inspection was completed with LMA representative, J. Caruso. (N. Cholewinski - GEI) FIELD_STRUCT_DESC: 1 of 2: 36-inch corrugated metal storm drainage pipe (CMP) through the levee, 4.0 feet below the crown. Flap gate on the waterside (WS) end. Concrete U-shaped headwalls on both ends. Cobble grouted spillway on the WS end. Cobble grouted intake on the landside (LS). [Additional Reference(s): DWR Levee Log, 1990, (HLM 14.16). USACE San Joaquin O&M Manual 612.2, 1967, (HLM 14.16)]. FS Date: 2/23/2021

Crown Overview

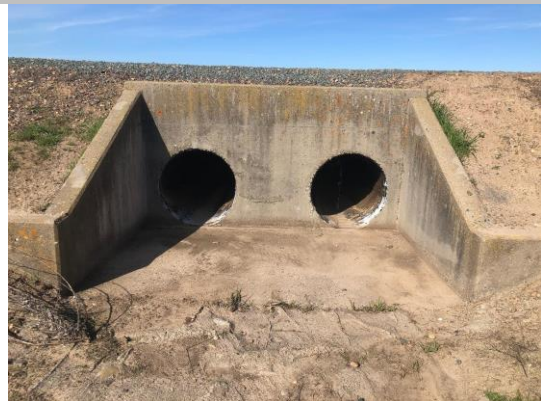
Photo 2 of 3 : UCIP_FA_2022_77547_92519.jpg

LS View: Headwall at LS toe.

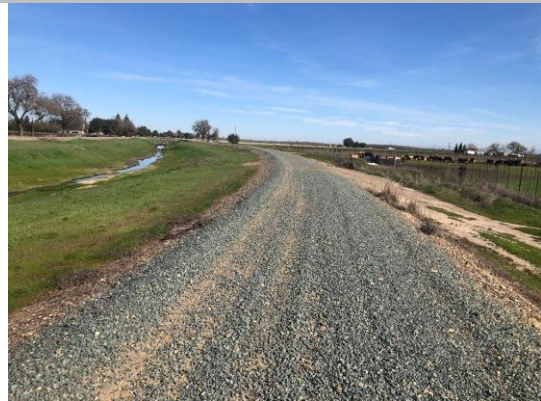
Photo 1 of 3 : UCIP_FA_2022_77548_92508.jpg

DS_ID:23815
 FS_ID:77548
 EP_NO: N/A
 Repair Type: Non-Urgent
 EVAL Issue:
 Crossing Status: Found
 UCIP Comments: 02/23/2021 Record was updated from No Action Needed to Non-Urgent. No permit was found authorizing this encroachment. CVFPB will need to review crossing to determine owner. DWR DMP has not found internal issues, LOF between 1 and 2. Recommend inspection in 5 years. The UCIP inspection was completed with LMA representative, J. Caruso. (N. Cholewinski – GEI)
 FIELD_STRUCT_DESC: 2 of 2: 36-inch corrugated metal storm drainage pipe (CMP) through the levee, 4.0 feet below the crown. Flap gate on the waterside (WS) end. Concrete U-shaped headwalls on both ends. Cobble grouted spillway on the WS end. Cobble grouted intake on the landside (LS). [Additional Reference(s): DWR Levee Log, 1990, (HLM 14.16). USACE San Joaquin O&M Manual 612.2, 1967, (HLM 14.16)].
 FS Date: 2/23/2021

Crown Overview

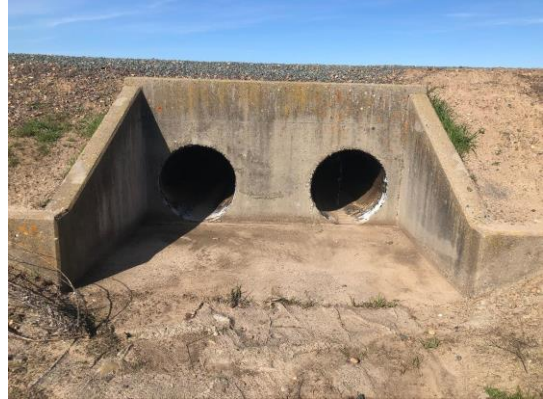
Photo 2 of 3 : UCIP_FA_2022_77548_92510.jpg

LS View: Headwall at LS toe.

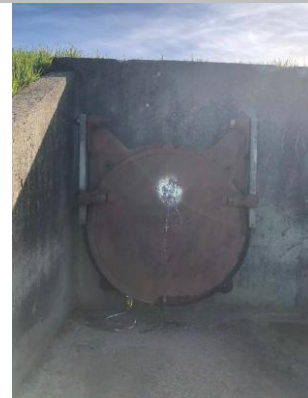
Photo 3 of 3 : UCIP_FA_2022_77548_92514.jpg

WS View: Headwall and flapgate on WS slope.

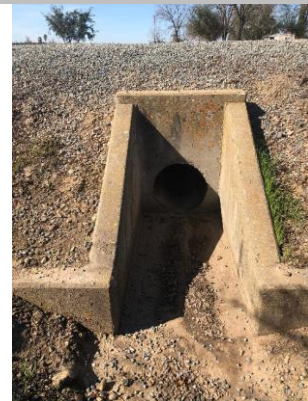
Photo 2 of 3 : UCIP_FA_2022_77550_92495.jpg

LS View: Headwall at LS toe.

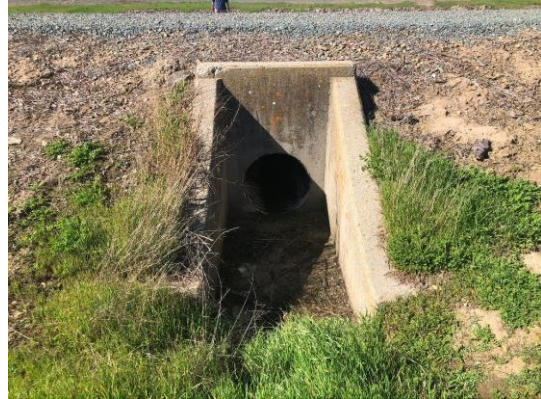
Photo 2 of 3 : UCIP_FA_2022_77551_92487.jpg

LS View: Headwall at LS toe.

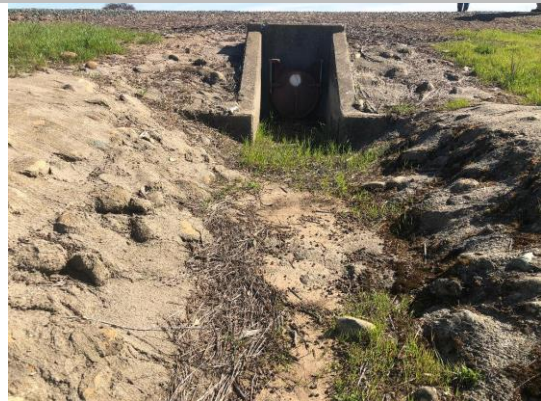
Photo 3 of 3 : UCIP_FA_2022_77551_92491.jpg

WS View: Headwall and flapgate at WS slope.

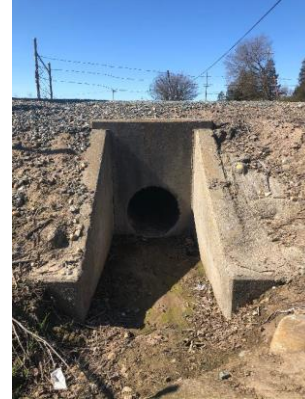
Photo 1 of 2 : UCIP_FA_2022_77553_92472.jpg

Comment Code					
Inspector Comment					
DS_ID:23778 FS_ID:77553 EP_NO: N/A Repair Type: Non-Urgent EVAL Issue: Crossing Status: Found UCIP Comments: 02/23/2021 Pipe status is still Non-Urgent. No permit was found authorizing this encroachment. CVFPB will need to review crossing to determine owner. DWR DMP has not found internal issues, LOF between 1 and 2. Recommend inspection in 5 years. The UCIP inspection was completed with LMA representative, J. Caruso. (N. Cholewinski – GEI)05/21/2014 Some silt buildup inside pipe. (W. Wylie - DWR DMP) FIELD_STRUCT_DESC: 24-inch corrugated metal storm drainage pipe (CMP) through the levee, 4.0 feet below the crown. Flap gate on the waterside (WS) end. Concrete U-shaped headwalls on both ends. Cobble grouted spillway on the WS end. Cobble grouted intake on the landside (LS). [Additional Reference(s): DWR Levee Log, 1990, (HLM 14.69). USACE San Joaquin O&M Manual 612.2, 1967, (HLM 14.69)]. FS Date: 2/23/2021

LS View: Headwall at LS toe.

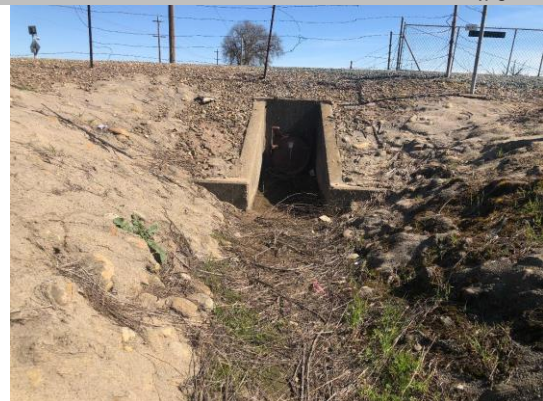
Photo 2 of 2 : UCIP_FA_2022_77553_92475.jpg

WS View: Headwall and flapgate on WS slope.

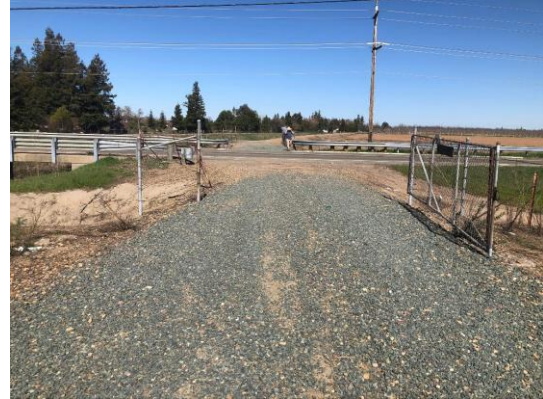
Photo 1 of 3 : UCIP_FA_2022_77555_92457.jpg

Comment Code						
Inspector Comment						
DS_ID:23779 FS_ID:77555 EP_NO: N/A Repair Type: Non-Urgent EVAL Issue: Crossing Status: Found UCIP Comments: 02/23/2021 Record was updated from No Action Needed to Non-Urgent . No permit was found authorizing this encroachment. CVFPB will need to review crossing to determine owner. DWR DMP has not found internal issues, LOF between 1 and 2. Recommend inspection in 5 years. The UCIP inspection was completed with LMA representative, J. Caruso. (N. Cholewinski - GEI) FIELD_STRUCT_DESC: 24-inch corrugated metal storm drainage pipe (CMP) through the levee, 6.5 feet below the crown. Flap gate on the waterside (WS) end. Concrete U-shaped headwalls on both ends. Cobble grouted spillway on the WS end. Cobble grouted intake on the landside (LS). [Additional Reference(s): DWR Levee Log, 1990, (HLM 14.70). USACE San Joaquin O&M Manual 612.2, 1967, (HLM 14.70)]. FS Date: 2/23/2021

Crown Overview - Utility across road.

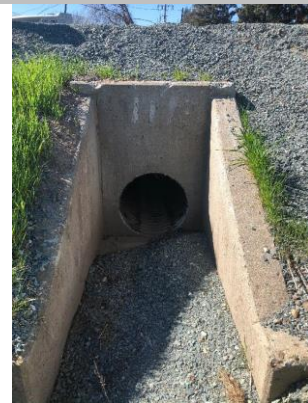
Photo 2 of 3 : UCIP_FA_2022_77555_92459.jpg

LS View: Headwall at LS toe.

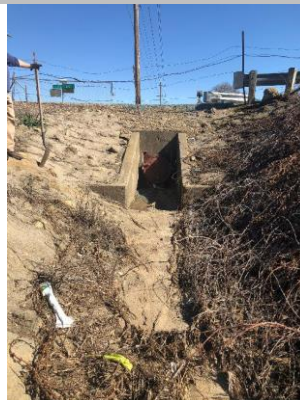
Photo 3 of 3 : UCIP_FA_2022_77555_92463.jpg

WS View: Headwall and flapgate on WS slope.

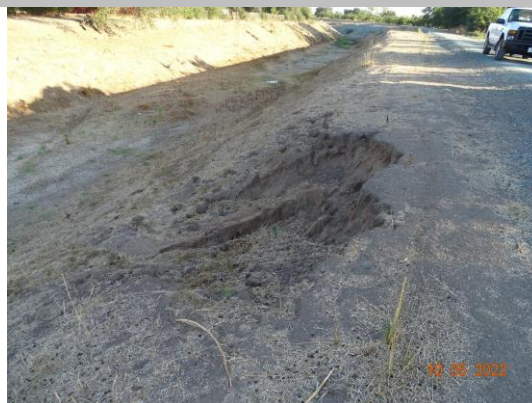
Photo 1 of 1 : FA_2022_NA0017_152_154_20221025_00396.jpg

LM Start	14.63	Rating **	U	Issue No.	154
LM End	14.63	Issue Type +	Ma	Location *	WS
Category	Earthen Levee			GPS Latitude/Longitude	
				Start	End
Item	Erosion / Bank Caving			38.120476 °	38.120476 °
				-121.169664 °	-121.169664 °
DWR ID	DWR_NA0017_08_s_2022_154				
Comment Code					
E2 : Schedule repair of erosion site prior to the next inspection.					
Inspector Comment					
There is caving along the waterside bank near the shoulder. It measures approximately 12 ft wide, 4 ft deep, 12 ft long.

View of erosion on the waterside slope. Fall 2022

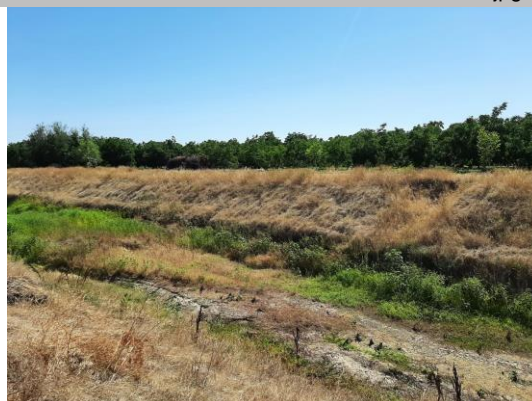
Photo 1 of 2 : SJR2022_NA0017U08RM21.46_3.jpg

*This area is patrol road only and therefore the site is not rated
07/13/2022: No significant changes were observed during the annual survey.

06/22/2021: A large rodent hole was discovered at the bank toe a few feet upstream of the erosion. Otherwise, no significant changes were observed during the annual survey.

07/31/2020: Observed two scour locations at the toe, beneath the existing erosion, approximately 5 ft long and 3 to 4 high. Also noticed some signs of burrow activity.

08/01/2019: Erosion likely has been caused by rainfall runoff.

7/13/2022: View of the erosion looking upstream.

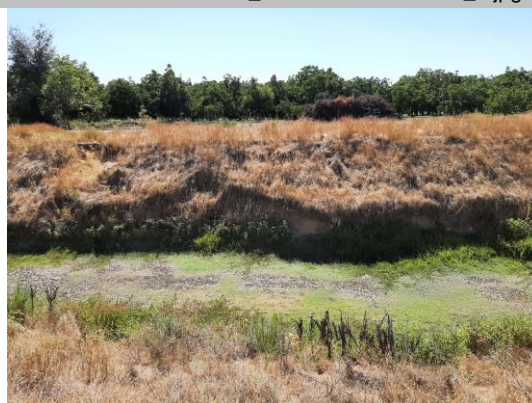
Photo 2 of 2 : SJR2022_NA0017U08RM21.46_4.jpg

7/13/2022: View of the erosion from the opposite bank.

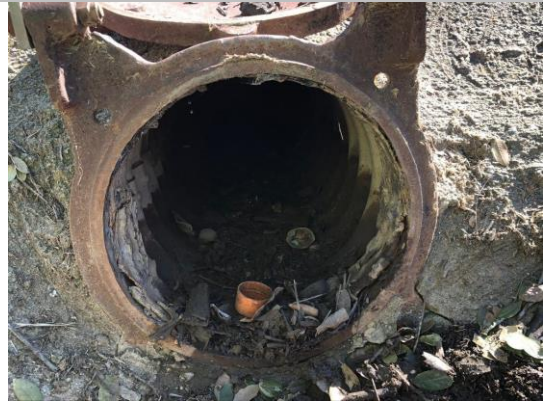
Photo 3 of 3 : UCIP_FA_2022_77556_92455.jpg

WS View: Pipe slightly corroded at outlet. Moisture observed in pipe, possible leakage occurring.

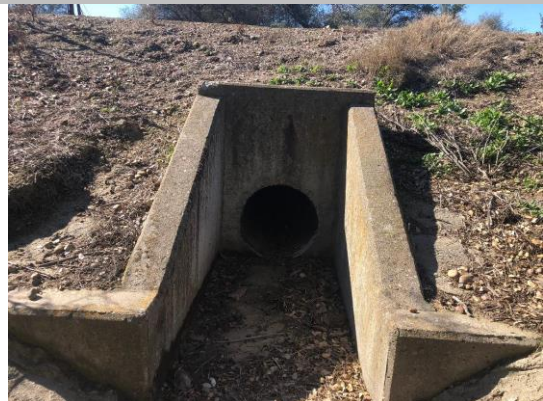
Photo 1 of 3 : UCIP_FA_2022_77557_92398.jpg

DS_ID:23781
 FS_ID:77557
 EP_NO: N/A
 Repair Type: Non-Urgent
 EVAL Issue:
 Crossing Status: Found
 UCIP Comments: 02/23/2021 Record was updated from No Action Needed to Non-Urgent. No permit was found authorizing this encroachment. CVFPB will need to review crossing to determine owner. DWR DMP has not found internal issues, LOF between 1 and 2. Recommend inspection in 5 years. Tree on downstream side of WS headwall is causing slight separation between headwall and apron, 1- to 2-inch gap. The UCIP inspection was completed with LMA representative, J. Caruso. (N. Cholewinski - GEI)
 FIELD_STRUCT_DESC: 24-inch corrugated metal storm drainage pipe (CMP) through the levee, 6.0 feet below the crown. Flap gate on the waterside (WS) end. Concrete U-shaped headwalls on both ends. Cobble grouted spillway on the WS end. Cobble grouted intake on the landside (LS). [Additional Reference(s): DWR Levee Log, 1990, (HLM 15.24). USACE San Joaquin O&M Manual 612.2, 1967, (HLM 15.24)].

LS View: Headwall at LS toe.

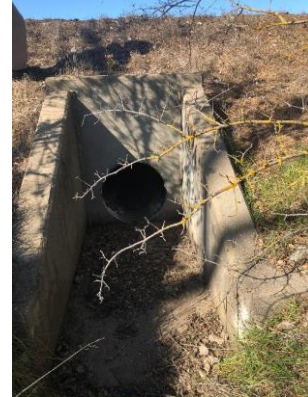
Photo 1 of 3 : UCIP_FA_2022_77559_92360.jpg

Comment Code						
Inspector Comment						
DS_ID:23782 FS_ID:77559 EP_NO: N/A Repair Type: Non-Urgent EVAL Issue: Crossing Status: Found UCIP Comments: 02/23/2021 Record was updated from No Action Needed to Non-Urgent No permit was found authorizing this encroachment. CVFPB will need to review crossing to determine owner. DWR DMP has not found internal issues, LOF between 1 and 2. Recommend inspection in 5 years. The UCIP inspection was completed with LMA representative, J. Caruso. (N. Cholewinski - GEI) FIELD_STRUCT_DESC: 24-inch corrugated metal storm drainage pipe (CMP) through the levee, 6.0 feet below the crown. Flap gate on the waterside (WS) end. Concrete U-shaped headwalls on both ends. Cobble grouted spillway on the WS end. Cobble grouted intake on the landside (LS). [Additional Reference(s): DWR Levee Log, 1990, (HLM 15.44). USACE San Joaquin O&M Manual 612.2, 1967, (HLM 15.44)]. FS Date: 2/23/2021

LS View: Headwall at LS toe.

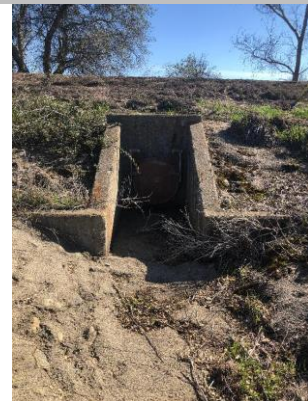
Photo 2 of 3 : UCIP_FA_2022_77559_92366.jpg

WS View: Headwall and flapgate on WS slope.

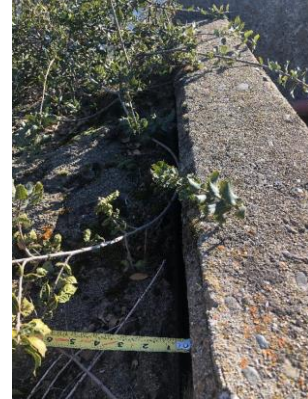
Photo 3 of 3 : UCIP_FA_2022_77559_92367.jpg

WS View: Small gap present on upstream side of headwall.

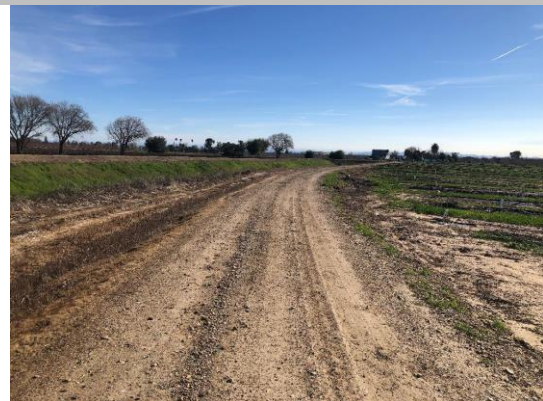
Photo 1 of 3 : UCIP_FA_2022_77567_92186.jpg

DS_ID:23784
 FS_ID:77567
 EP_NO: N/A
 Repair Type: Non-Urgent
 EVAL Issue:
 Crossing Status: Found
 UCIP Comments: 02/25/2021 Record changed from No Action Needed to Non-Urgent. No permit was found authorizing this encroachment. CVFPB will need to review crossing to determine owner. DWR DMP has not found internal issues, LOF between 1 and 2. Recommend inspection in 5 years. Observed slight damage to concrete on LS headwall toe, but no noticeable integrity issues. The UCIP inspection was completed with LMA representative, J. Caruso. (N. Cholewinski - GEI)
 FIELD_STRUCT_DESC: 24-inch corrugated metal storm drainage pipe (CMP) through the levee, 3.0 feet below the crown. Flap gate on the waterside (WS) end. Concrete U-shaped headwalls on both ends. Cobble grouted spillway on the WS end. Cobble grouted intake on the landside (LS). [Additional Reference(s): DWR Levee Log, 1990, (HLM 16.02). USACE San Joaquin O&M Manual 612.2, 1967, (HLM 16.02)].

Top of Levee

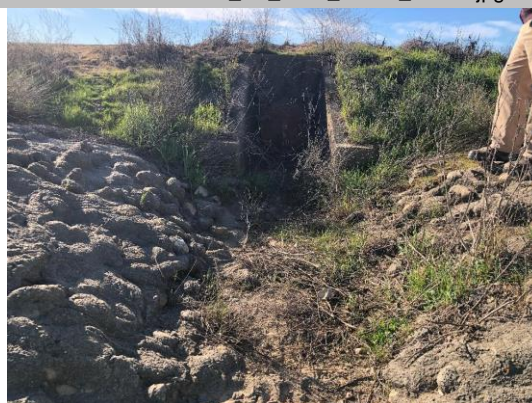
Photo 3 of 3 : UCIP_FA_2022_77567_92192.jpg

WS View: Headwall and 24-inch flapgate at WS slope.

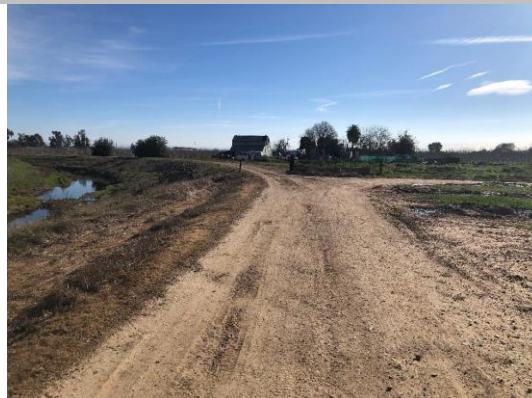
Photo 1 of 3 : UCIP_FA_2022_77568_92179.jpg

Comment Code						
Inspector Comment						
DS_ID:23785 FS_ID:77568 EP_NO: N/A Repair Type: Non-Urgent EVAL Issue: Crossing Status: Found UCIP Comments: 02/25/2021 Record changed from No Action Needed to Non-Urgent. No permit was found authorizing this encroachment. CVFPB will need to review crossing to determine owner. DWR DMP has not found internal issues, LOF between 1 and 2. Recommend inspection in 5 years. The UCIP inspection was completed with LMA representative, J. Caruso. (N. Cholewinski - GEI) FIELD_STRUCT_DESC: 24-inch corrugated metal storm drainage pipe (CMP) through the levee, 1.5 feet below the crown. Flap gate on the waterside (WS) end. Concrete U-shaped headwalls on both ends. Cobble grouted spillway on the WS end. Cobble grouted intake on the landside (LS). [Additional Reference(s): DWR Levee Log, 1990, (HLM 16.15). USACE San Joaquin O&M Manual 612.2, 1967, (HLM 16.15)]. FS Date: 2/25/2021

Top of Levee

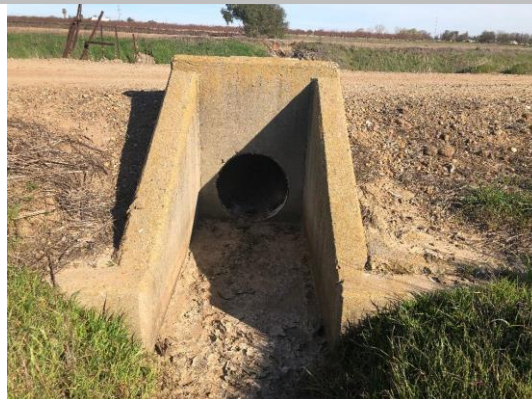
Photo 2 of 3 : UCIP_FA_2022_77568_92181.jpg

LS View: Headwall at LS toe.

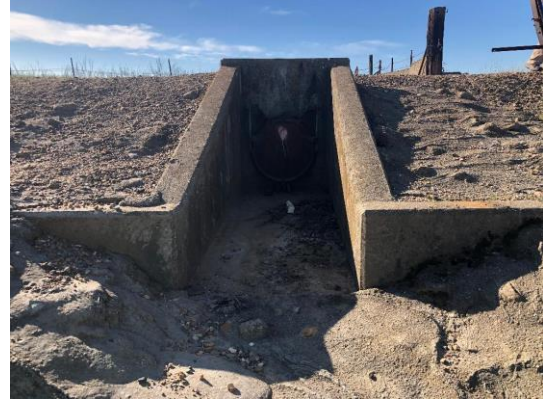
Photo 3 of 3 : UCIP_FA_2022_77568_92184.jpg

WS View: Headwall and 24-inch flapgate at WS slope.

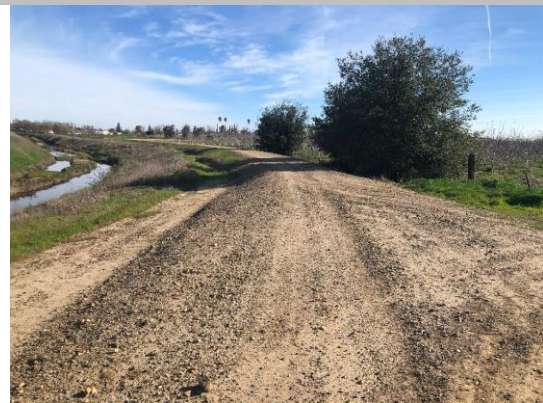
Photo 1 of 3 : UCIP_FA_2022_77569_92169.jpg

Top of Levee

Comment Code					
Inspector Comment					
DS_ID:23786 FS_ID:77569 EP_NO: N/A Repair Type: Urgent EVAL Issue: 1, Pipe Integrity Crossing Status: Found UCIP Comments: 02/25/2021 Record was updated from No Action Needed to Urgent due to a corroded through pipe wall at the WS pipe outlet and leakage observed at the LS pipe inlet. DWR DMP has found integrity issues, LOF between 5 and 6. Crossing will be monitored until funding becomes available for removal. No permit was found authorizing this encroachment. CVFPB will need to review crossing to determine owner. An additional 1-inch steel pipe oriented parallel to levee was observed approximately 1 foot adjacent to LS headwall at LS toe. The UCIP inspection was completed with LMA representative, J. Caruso. (N. Cholewinski - GEI) FIELD_STRUCT_DESC: 24-inch corrugated metal storm drainage pipe (CMP) through the levee, 8.0 feet below the crown. Flap gate on the waterside (WS) end. Concrete U-shaped headwalls on both ends. Cobble grouted spillway on the WS end. Cobble grouted intake on the landside (LS). [Additional Reference(s): DWR Levee Log, 1990, (HLM 16.22). USACE San Joaquin O&M Manual 612.2, 1967, (HLM 16.22)]. FS Date: 2/25/2021

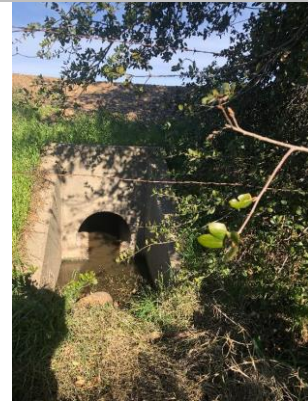
Photo 2 of 3 : UCIP_FA_2022_77569_92171.jpg

Headwall at LS toe.

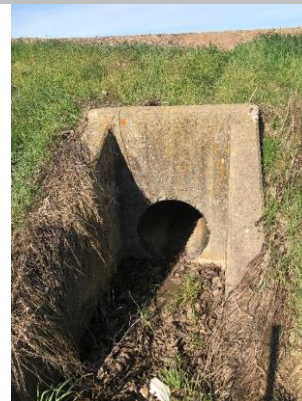
Photo 2 of 3 : UCIP_FA_2022_77570_92162.jpg

Concrete headwall on LS toe.

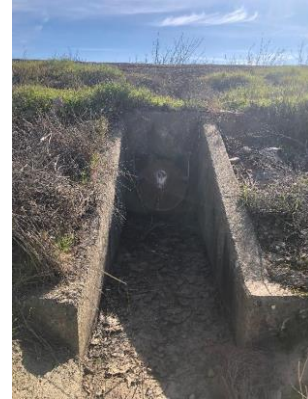
Photo 3 of 3 : UCIP_FA_2022_77570_92167.jpg

Headwall with 24-inch flapgate at WS toe.

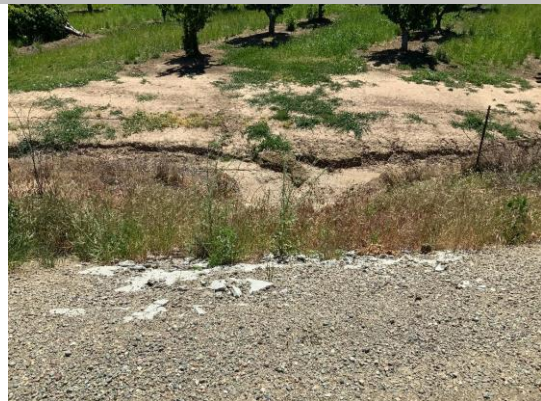
Photo 2 of 3 : UCIP_FA_2022_77575_96877.jpg

LS view: Toe from crown.

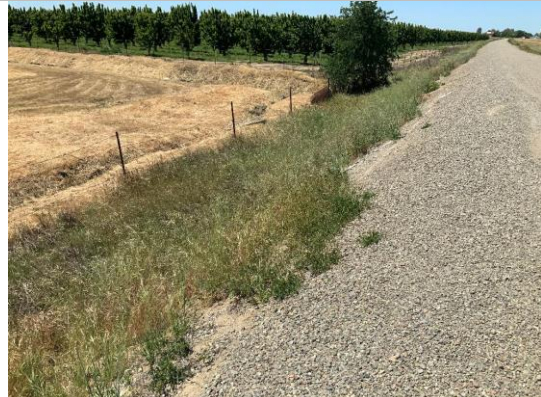
Photo 2 of 3 : UCIP_FA_2022_77577_96888.jpg

LS view: Slope from crown, no pipe visible.

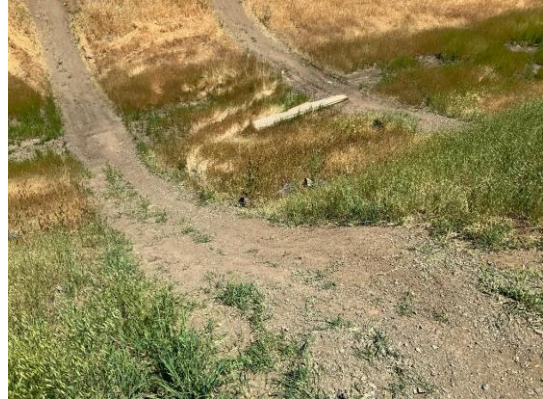
Photo 3 of 3 : UCIP_FA_2022_77577_96890.jpg

WS view: Slope from crown, no pipe visible.

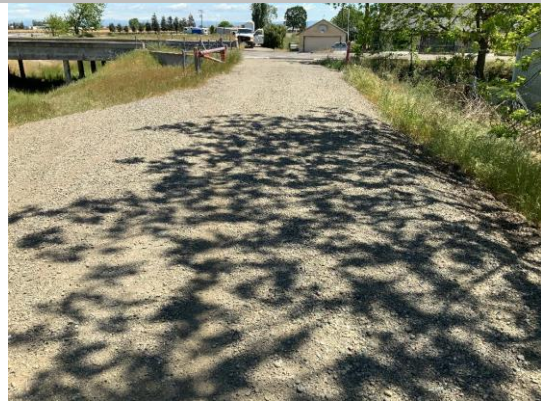
Photo 1 of 3 : UCIP_FA_2022_77578_96893.jpg

Comment Code						
Inspector Comment						
DS_ID:23853 FS_ID:77578 EP_NO: N/A Repair Type: Non-Urgent EVAL Issue: Crossing Status: Found UCIP Comments: 04/27/2021 The record has been upgraded from No Action Needed to Non-Urgent. DWR DMP internal inspection has not found pipe integrity issues. LOF of crossing is less or equal to 4.0. Recommend next inspection in 5 years. No permit was found authorizing this encroachment. CVFPB will need to review crossing to determine owner. The UCIP inspection was completed with LMA representative, J. Nelson. (H. Dunn – GEI) FIELD_STRUCT_DESC: 24-inch corrugated metal storm drainage pipe (CMP) through the levee, 4.5 feet below the crown. Flap gate on the waterside (WS) end. Concrete U-shaped headwalls on both ends. Cobble grouted spillway on the WS end. Cobble grouted intake on the landside (LS). [Additional Reference(s): DWR Levee Log, 1987, (HLM 0.56). USACE San Joaquin O&M Manual 612.2, 1967, (HLM 0.56)]. FS Date: 4/27/2021

Levee crown looking upstream.

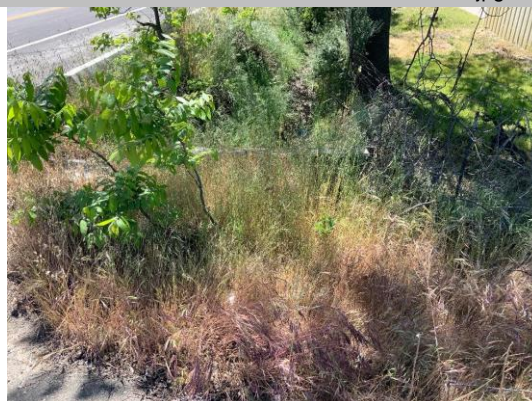
Photo 2 of 3 : UCIP_FA_2022_77578_96894.jpg

LS view: Toe from crown.

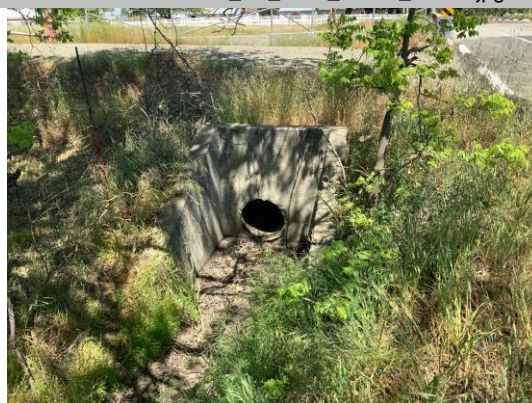
Photo 3 of 3 : UCIP_FA_2022_77578_96895.jpg

LS view: Slope and headwall at toe.

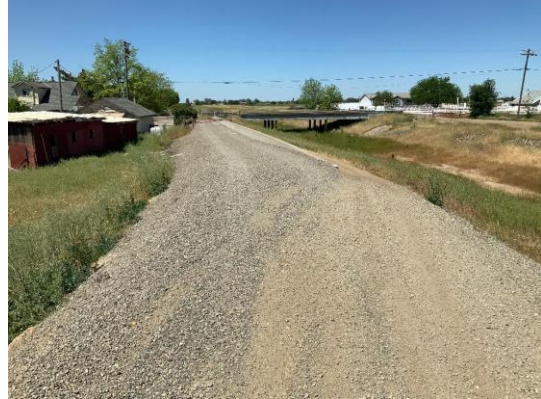
Photo 1 of 3 : UCIP_FA_2022_77579_96901.jpg

Comment Code					
Inspector Comment					
DS_ID:23839 FS_ID:77579 EP_NO: N/A Repair Type: No Action Needed EVAL Issue: Crossing Status: Found UCIP Comments: 04/27/2021 Pipe status is still No Action Needed. DWR DMP internal inspection has not found pipe integrity issues. LOF of crossing is less or equal to 4.0. Recommend next inspection in 5 years. The UCIP inspection was completed with LMA representative, J. Nelson. (H. Dunn – GEI) 06/19/2014 Suction hose and appurtances appear to be abandoned. (W. Wylie - DWR UCIP) FIELD_STRUCT_DESC: 24-inch corrugated metal storm drainage pipe (CMP) through the levee, 8.0 feet below the crown. Flap gate on the waterside (WS) end. Concrete U-shaped headwalls on both ends. Cobble grouted spillway on the WS end. Cobble grouted intake on the landside (LS). Pump with suction hose sleeved through the storm drainage pipe located on the LS—removed during winter months. (Suction hose authorized under Permit No. 11530, 1976 - Constantine M. Copulos). [Additional Reference(s): DWR Levee Log, 1987, (HLM 0.62). USACE San Joaquin O&M Manual 612.2, 1967, (HLM 0.62), and 612 (addendum), February 1999, (HLM 0.61), (Station 32+46)]. FS Date: 4/27/2021

Levee crown looking downstream.

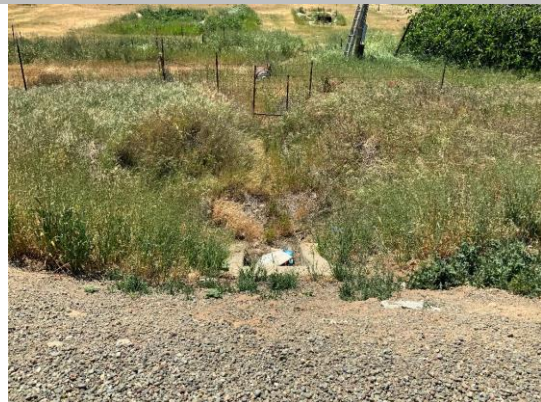
Photo 2 of 3 : UCIP_FA_2022_77579_96902.jpg

LS view: Headwall visible at toe from crown.

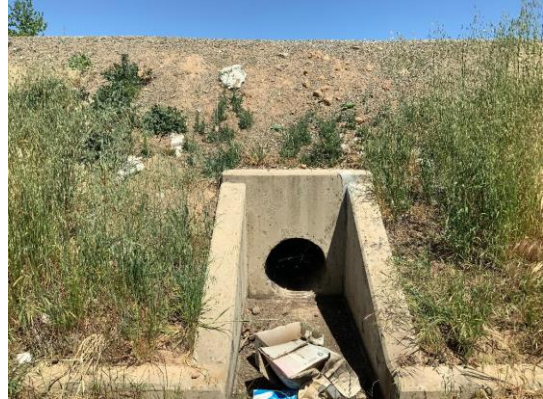
Photo 3 of 3 : UCIP_FA_2022_77579_96903.jpg

LS view: Slope and headwall at toe.

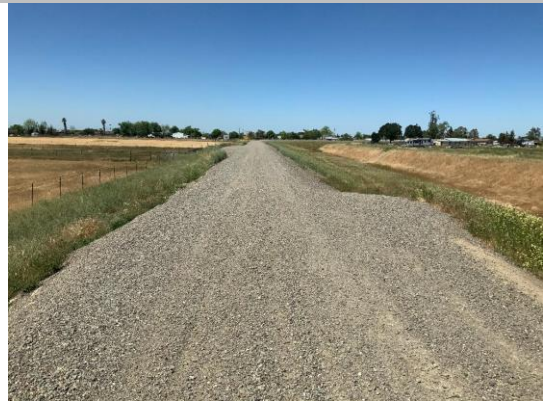
Photo 1 of 3 : UCIP_FA_2022_77580_96906.jpg

DS_ID:23840
 FS_ID:77580
 EP_NO: N/A
 Repair Type: Non-Urgent
 EVAL Issue:
 Crossing Status: Found
 UCIP Comments: 04/27/2021 The record has been upgraded from No Action Needed to Non-Urgent. Did not inspect LS headwall due to steep slope and slippery rubble. DWR DMP internal inspection has not found pipe integrity issues. LOF of crossing is less or equal to 4.0. Recommend next inspection in 5 years. No permit was found authorizing this encroachment. CVFPB will need to review crossing to determine owner. The UCIP inspection was completed with LMA representative, J. Nelson. (H. Dunn – GEI)
 FIELD_STRUCT_DESC: 24-inch corrugated metal storm drainage pipe (CMP) through the levee, 7.0 feet below the crown. Flap gate on the waterside (WS) end. Concrete U-shaped headwalls on both ends. Cobble grouted spillway on the WS end. Cobble grouted intake on the landside (LS). [Additional Reference(s): DWR Levee Log, 1987, (HLM 0.86). USACE San Joaquin O&M Manual 612.2, 1967, (HLM 0.86)].

Levee crown looking downstream.

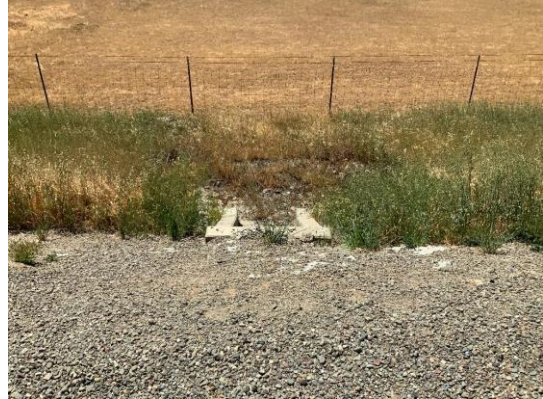
Photo 2 of 3 : UCIP_FA_2022_77580_96907.jpg

LS view: Headwall visible at toe from crown.

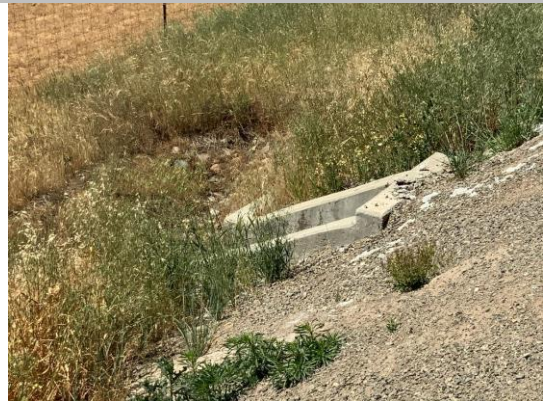
Photo 3 of 3 : UCIP_FA_2022_77580_96905.jpg

LS view: Slope and headwall from crown.

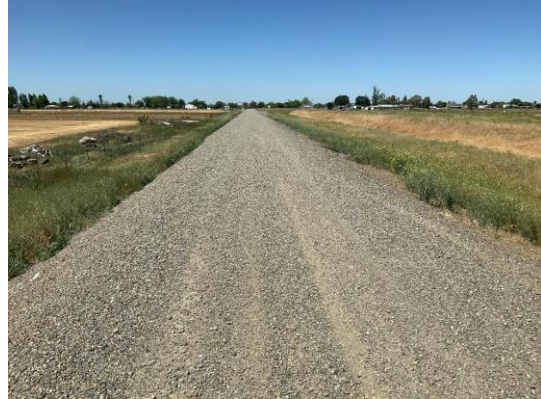
Photo 1 of 3 : UCIP_FA_2022_77582_96917.jpg

Comment Code						
Inspector Comment						
DS_ID:23841 FS_ID:77582 EP_NO: N/A Repair Type: Non-Urgent EVAL Issue: 5, Pipe Damage Crossing Status: Found UCIP Comments: 04/27/2021 Pipe status is still Non-Urgent. DWR DMP internal inspection has found pipe integrity issues. LOF of crossing is between 4.1 and 5. Crossing will be monitored until funding becomes available for rehabilitation. No permit was found authorizing this encroachment. CVFPB will need to review crossing to determine owner. The UCIP inspection was completed with LMA representative, J. Nelson. (H. Dunn – GEI) 06/19/2014 Sediment buildup inside pipe. (W. Wylie -DWR UCIP) FIELD_STRUCT_DESC: 12-inch corrugated metal storm drainage pipe (CMP) through the levee, 7.0 feet below the crown. Flap gate on the waterside (WS) end. Headwall at the landside (LS) toe. Cobble grouted spillway on the WS end. [Additional Reference(s): DWR Levee Log, 1987, (HLM 0.94). USACE San Joaquin O&M Manual 612 (addendum), February 1999, (HLM 0.93), (Station 49+30)]. FS Date: 4/27/2021

Levee crown looking downstream.

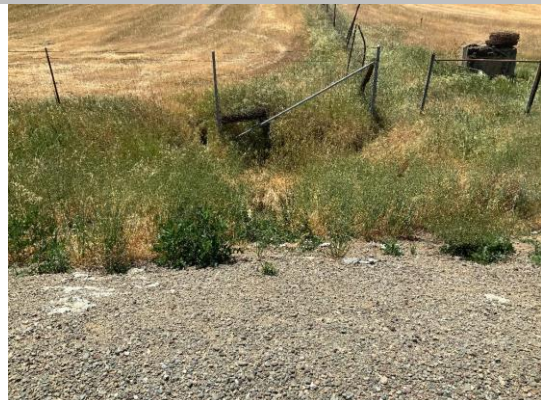
Photo 2 of 3 : UCIP_FA_2022_77582_96919.jpg

LS view: Toe from crown.

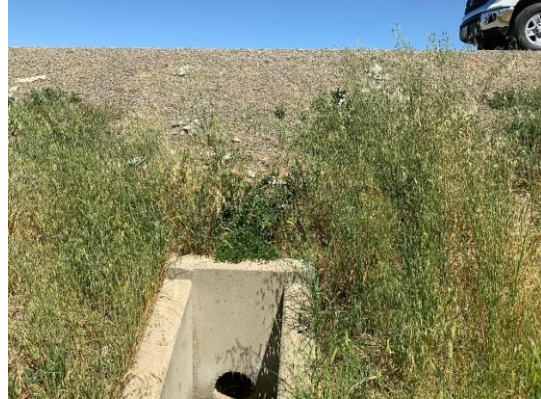
Photo 3 of 3 : UCIP_FA_2022_77582_96920.jpg

LS view: Slope from toe.

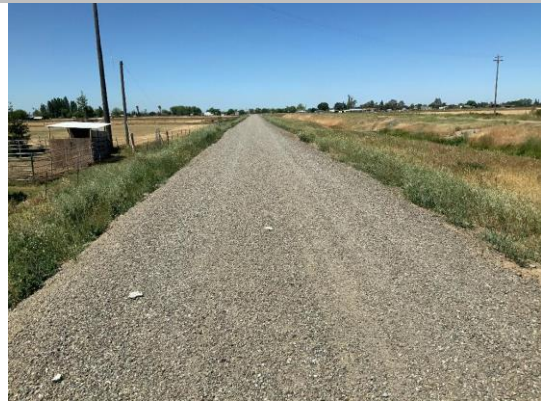
Photo 1 of 3 : UCIP_FA_2022_77583_96922.jpg

DS_ID:23858
 FS_ID:77583
 EP_NO: N/A
 Repair Type: Non-Urgent
 EVAL Issue:
 Crossing Status: Not Found
 UCIP Comments: 04/27/2021 The record has been upgraded from No Action Needed to Non-Urgent. Pipe not found by visual inspection. No permit was found authorizing this encroachment. CVFPB will need to review crossing to determine owner. The UCIP inspection was completed with LMA representative, J. Nelson. (H. Dunn – GEI)
 FIELD_STRUCT_DESC: 24-inch corrugated metal storm drainage pipe (CMP) through the levee, at an unknown depth. [Additional Reference(s): USACE San Joaquin O&M Manual 612 (addendum), February 1999, (HLM 1.02), (Station 54+05)].
 FS Date: 4/27/2021

Levee crown looking downstream.

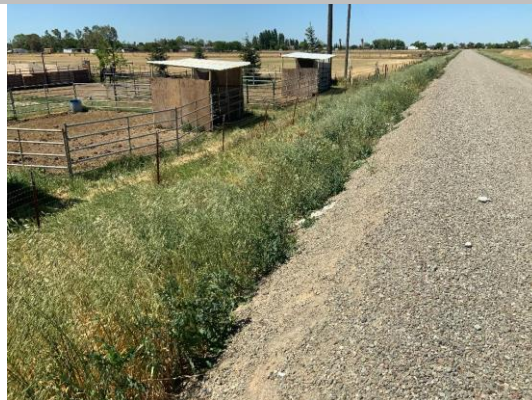
Photo 2 of 3 : UCIP_FA_2022_77583_96923.jpg

LS view: Slope from crown, no pipe visible.

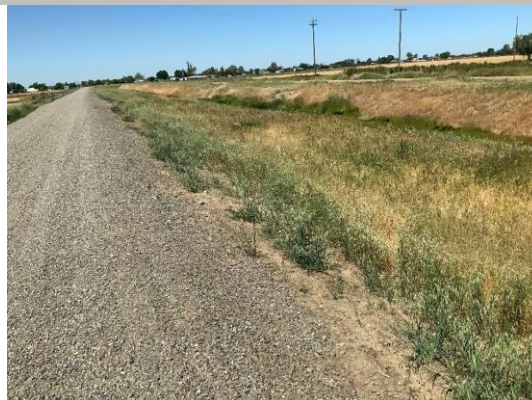
Photo 3 of 3 : UCIP_FA_2022_77583_96924.jpg

WS view: Slope from crown, no pipe visible.

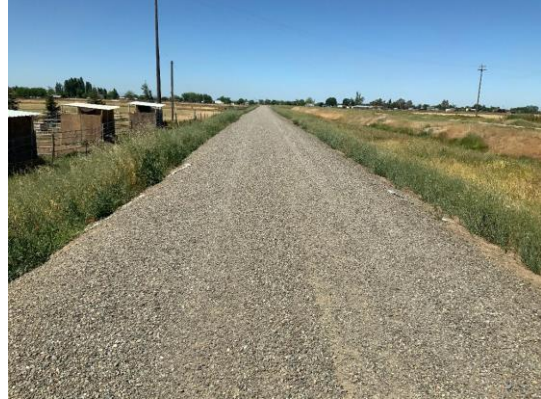
Photo 1 of 3 : UCIP_FA_2022_77584_96928.jpg

Comment Code					
Inspector Comment					
DS_ID:23842 FS_ID:77584 EP_NO: N/A Repair Type: Urgent EVAL Issue: 1, Pipe Integrity Crossing Status: Found UCIP Comments: 04/27/2021 The record has been upgraded from No Action Needed to Urgent. DWR DMP internal inspection has found pipe integrity issues. LOF of crossing is between 5 and 6. Crossing will be monitored until funding becomes available to address the issues. No permit was found authorizing this encroachment. CVFPB will need to review crossing to determine owner. The UCIP inspection was completed with LMA representative, J. Nelson. (H. Dunn – GEI) FIELD_STRUCT_DESC: 12-inch corrugated metal storm drainage pipe (CMP) through the levee, 6.0 feet below the crown. Flap gate on the waterside (WS) end. Cobble grouted spillway on the WS end. [Additional Reference(s): DWR Levee Log, 1987, (HLM 1.03). USACE San Joaquin O&M Manual 612.2, 1967, (HLM 1.03)]. FS Date: 4/27/2021

Levee crown looking downstream.

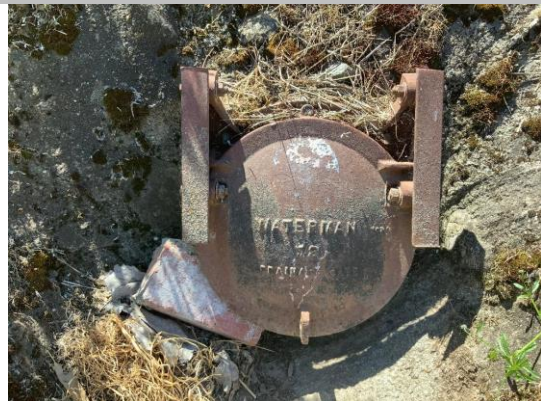
Photo 2 of 3 : UCIP_FA_2022_77584_96929.jpg

WS view: Close up of flapgate at toe.

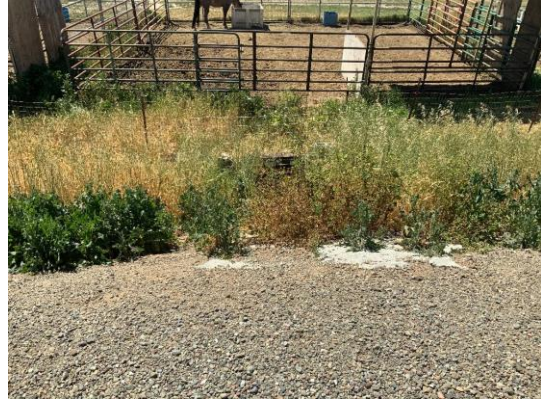
Photo 3 of 3 : UCIP_FA_2022_77584_96930.jpg

LS view: Toe from crown.

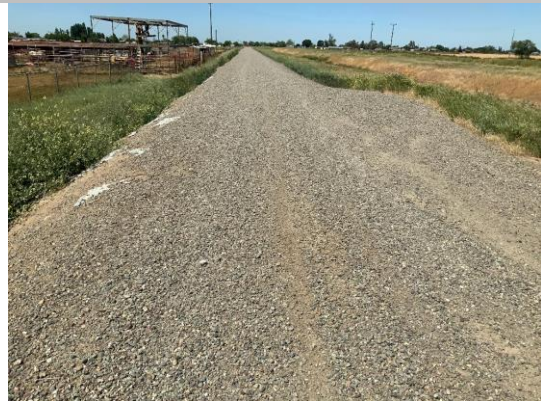
Photo 1 of 3 : UCIP_FA_2022_77585_96936.jpg

DS_ID:23843
 FS_ID:77585
 EP_NO: N/A
 Repair Type: Non-Urgent
 EVAL Issue:
 Crossing Status: Found
 UCIP Comments: 04/27/2021 The record has been upgraded from No Action Needed to Non-Urgent. DWR DMP internal inspection has not found pipe integrity issues. LOF of crossing is less or equal to 4.0. Recommend next inspection in 5 years. No permit was found authorizing this encroachment. CVFPB will need to review crossing to determine owner. The UCIP inspection was completed with LMA representative, J. Nelson. (H. Dunn – GEI)
 FIELD_STRUCT_DESC: 24-inch corrugated metal storm drainage pipe (CMP) through the levee, 4.5 feet below the crown. Flap gate on the waterside (WS) end. Concrete U-shaped headwalls on both ends. One corrugated metal cutoff wall. Cobble grouted spillway on the WS end. Cobble grouted intake on the landside (LS). [Additional Reference(s): DWR Levee Log, 1987, (HLM 1.09). USACE San Joaquin O&M Manual 612.2, 1967, (HLM 1.09), and 612 (addendum), February 1999, (HLM 1.09), (Station 57+30)].

Levee crown looking downstream.

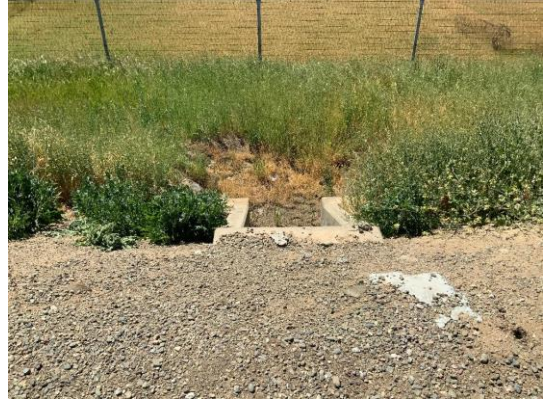
Photo 2 of 3 : UCIP_FA_2022_77585_96937.jpg

LS view: Headwall visible at toe from crown.

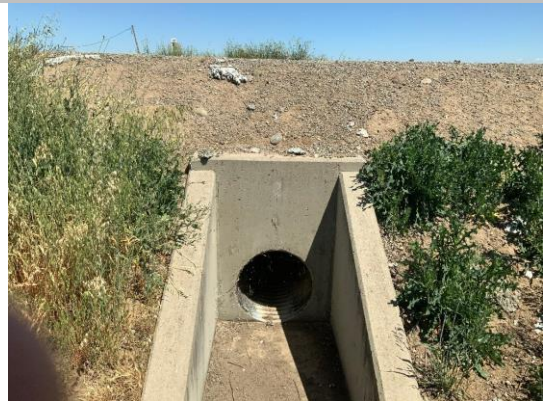
Photo 3 of 3 : UCIP_FA_2022_77585_96938.jpg

LS view: Slope and headwall at toe.

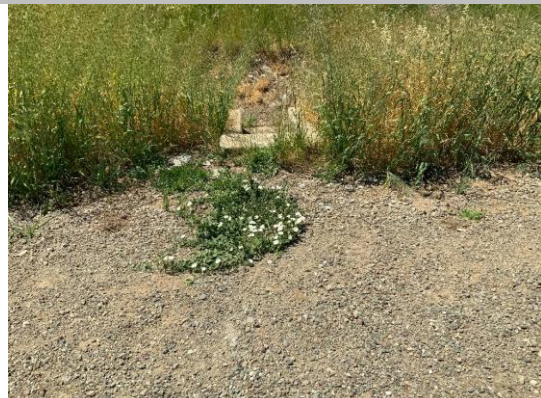
Photo 2 of 3 : UCIP_FA_2022_77586_96944.jpg

LS view: Headwall visible at toe from crown.

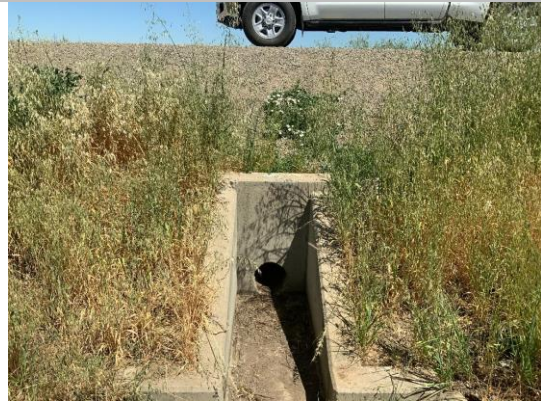
Photo 3 of 3 : UCIP_FA_2022_77586_96945.jpg

LS view: Slope and headwall at toe.

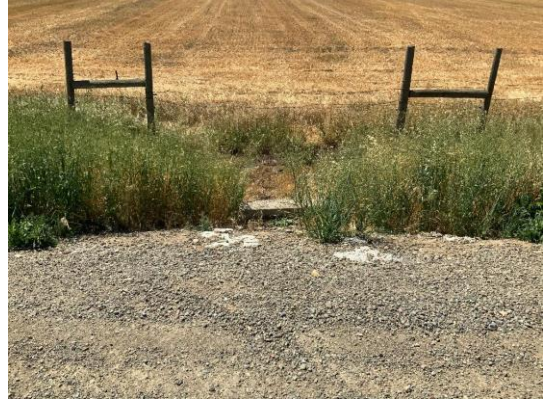
Photo 2 of 3 : UCIP_FA_2022_77587_96950.jpg

LS view: Headwall visible at toe from crown.

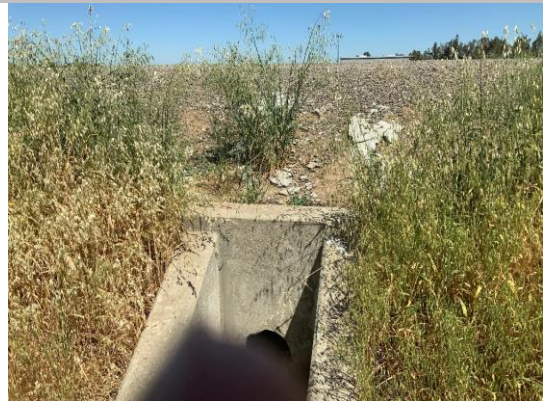
Photo 3 of 3 : UCIP_FA_2022_77587_96951.jpg

LS view: Slope and headwall at toe.

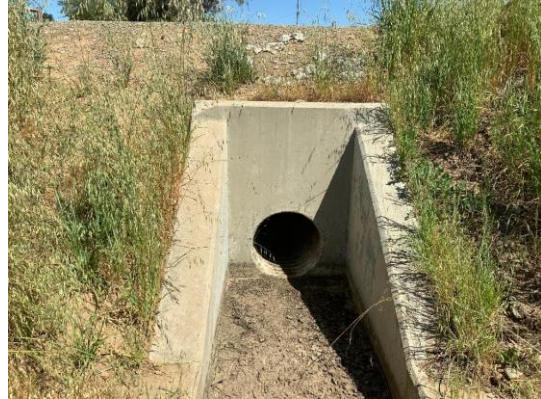
Photo 3 of 3 : UCIP_FA_2022_77589_96961.jpg

LS view: Slope and headwall at toe.

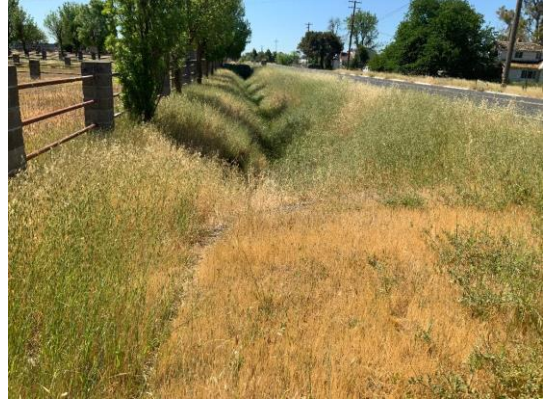
Photo 2 of 3 : UCIP_FA_2022_77590_96970.jpg

LS view: Toe from crown.

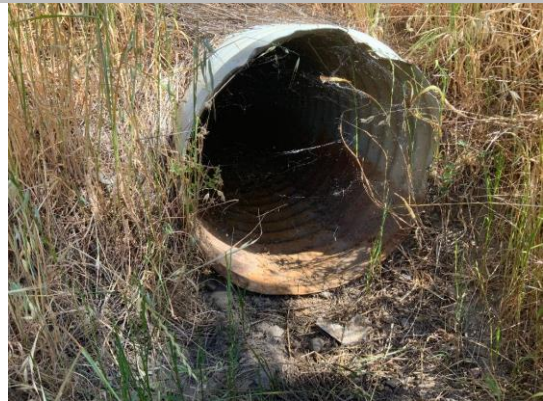
Photo 3 of 3 : UCIP_FA_2022_77590_96971.jpg

LS view: Close up of pipe inlet at toe, minor warping on edges.

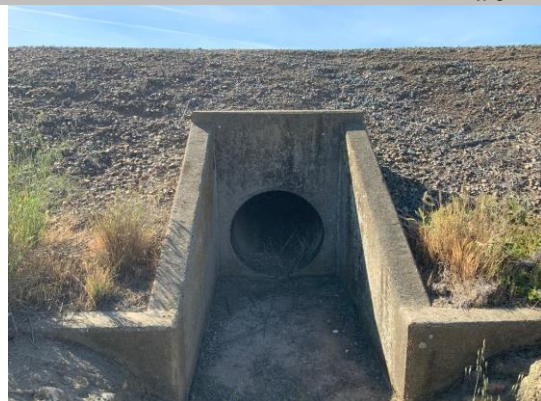
Photo 2 of 3 : UCIP_FA_2022_77592_97222.jpg

LS view: Slope and headwall at toe.
