**Flood Control Project Maintenance
Levee Inspections**

Maintenance Issue Types Only, Levee Inspection Report By Mile - Fall 2022

San Joaquin County Flood Control and Water Conservation District

Waterway	Bank	Unit Miles	Inspection Start/End	Inspector
Unit No. 01 Littlejohn Creek	Left	2.59	10/13/2022 10/13/2022	Alberto De Leon

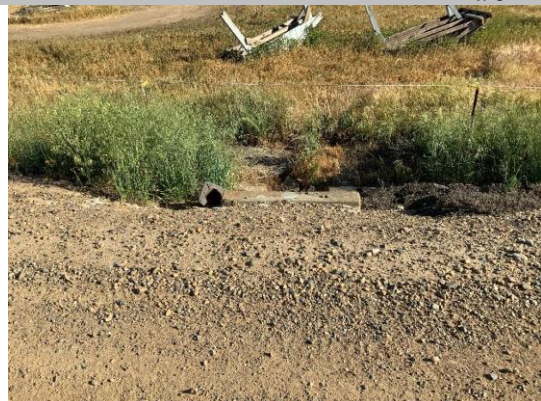
Photo 2 of 3 : UCIP_FA_2022_77594_97236.jpg

Comment Code					
Inspector Comment					
DS_ID:23861 FS_ID:77594 EP_NO: N/A Repair Type: Non-Urgent EVAL Issue: Crossing Status: Found UCIP Comments: 04/29/2021 The record has been upgraded from No Action Needed to Non-Urgent. DWR DMP internal inspection has not found pipe integrity issues. LOF of crossing is less or equal to 4.0. Recommend inspection in 5 years. No permit was found authorizing this encroachment. CVFPB will need to review crossing to determine owner. The UCIP inspection was completed with LMA representative, J. Nelson. (H. Dunn – GEI) FIELD_STRUCT_DESC: 24-inch corrugated metal storm drainage pipe (CMP) through the levee, 5.0 feet below the crown. Flap gate on the waterside (WS) end. Concrete U-shaped headwalls on both ends. Cobble grouted spillway on the WS end. Cobble grouted intake on the landside (LS). [Additional Reference(s): DWR Levee Log, 1978, (HLM 0.36). USACE San Joaquin O&M Manual 612.2, 1967, (HLM 0.36)]. FS Date: 4/29/2021

LS view: Headwall visible at toe from crown.

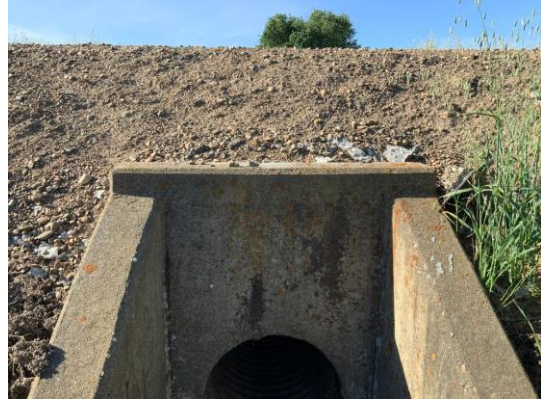
Photo 3 of 3 : UCIP_FA_2022_77594_97237.jpg

LS view: Slope and headwall at toe.

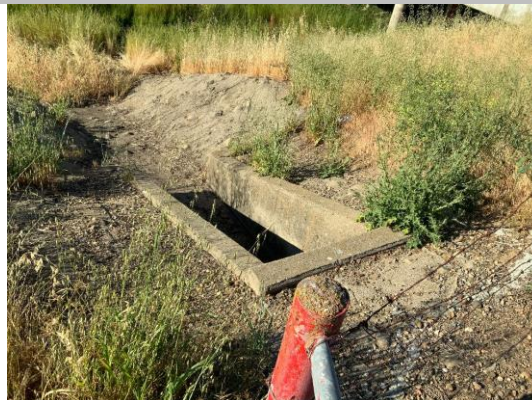
Photo 2 of 3 : UCIP_FA_2022_77596_97248.jpg

DS_ID:23863
FS_ID:77596
EP_NO: N/A
Repair Type: Non-Urgent
EVAL Issue:
Crossing Status: Found
UCIP Comments: 04/29/2021 The record has been upgraded from No Action Needed to Non-Urgent. DWR DMP internal inspection has not found pipe integrity issues. LOF of crossing is less or equal to 4.0. Something is peeling away inside the pipe inlet, possibly just the liner. No permit was found authorizing this encroachment. CVFPB will need to review crossing to determine owner. The UCIP inspection was completed with LMA representative, J. Nelson. (H. Dunn – GEI)
FIELD_STRUCT_DESC: 24-inch corrugated metal storm drainage pipe (CMP) through the levee, 4.0 feet below the crown. Flap gate on the waterside (WS) end. Concrete U-shaped headwalls on both ends. Cobble grouted spillway on the WS end. Cobble grouted intake on the landside (LS). [Additional Reference(s): DWR Levee Log, 1978, (HLM 0.46). USACE San Joaquin O&M Manual 612.2, 1967, (HLM 0.46)].

WS view: Headwall visible at toe from crown.

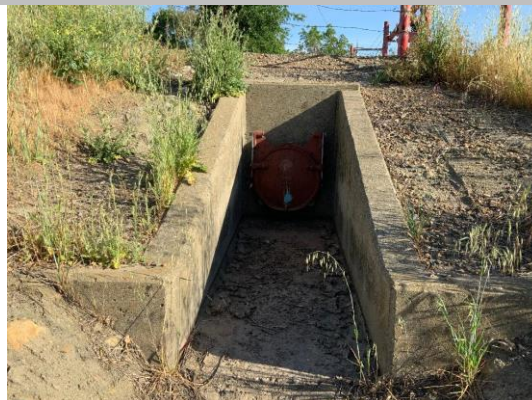
Photo 3 of 3 : UCIP_FA_2022_77596_97249.jpg

WS view: Slope, headwall, and flapgate at toe.

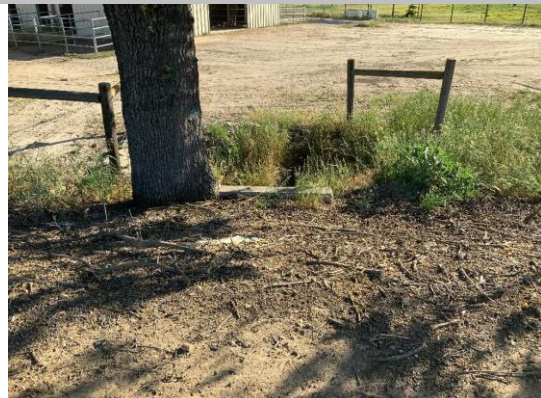
Photo 2 of 3 : UCIP_FA_2022_77597_97259.jpg

Comment Code						
Inspector Comment						
DS_ID:23864 FS_ID:77597 EP_NO: N/A Repair Type: Non-Urgent EVAL Issue: Crossing Status: Found UCIP Comments: 04/29/2021 The record has been upgraded from No Action Needed to Non-Urgent. DWR DMP internal inspection has not found pipe integrity issues. LOF of crossing is less or equal to 4.0. Recommend inspection in 5 years. No permit was found authorizing this encroachment. CVFPB will need to review crossing to determine owner. The UCIP inspection was completed with LMA representative, J. Nelson. (H. Dunn – GEI) FIELD_STRUCT_DESC: 24-inch corrugated metal storm drainage pipe (CMP) through the levee, 5.0 feet below the crown. Flap gate on the waterside (WS) end. Concrete U-shaped headwalls on both ends. Cobble grouted spillway on the WS end. Cobble grouted intake on the landside (LS). (3-inch polyvinyl chloride [PVC] pipe sleeved through 24-inch pipe authorized under Permit No. 11617, 1976 - Tom Patterson). [Additional Reference(s): DWR Levee Log, 1978, (HLM 0.58). USACE San Joaquin O&M Manual 612.2, 1967, (HLM 0.58)]. FS Date: 4/29/2021

LS view: Headwall visible at toe from crown.

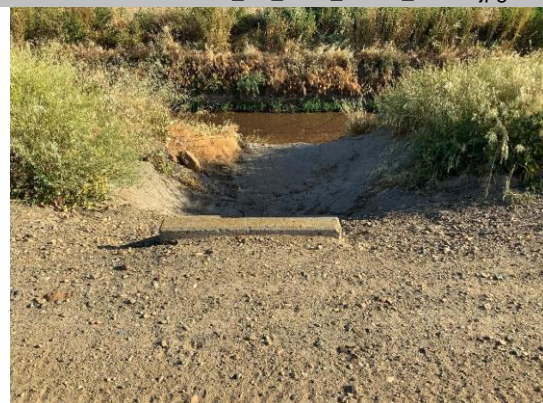
Photo 2 of 3 : UCIP_FA_2022_77598_97265.jpg

Comment Code						
Inspector Comment						
DS_ID:23865 FS_ID:77598 EP_NO: N/A Repair Type: Non-Urgent EVAL Issue: Crossing Status: Found UCIP Comments: 04/29/2021 The record has been upgraded from No Action Needed to Non-Urgent. DWR DMP internal inspection has not found pipe integrity issues. LOF of crossing is less or equal to 4.0. Recommend inspection in 5 years. No permit was found authorizing this encroachment. CVFPB will need to review crossing to determine owner. The UCIP inspection was completed with LMA representative, J. Nelson. (H. Dunn – GEI) FIELD_STRUCT_DESC: 24-inch corrugated metal storm drainage pipe (CMP) through the levee, 5.5 feet below the crown. Flap gate on the waterside (WS) end. Concrete U-shaped headwalls on both ends. Cobble grouted spillway on the WS end. Cobble grouted intake on the landside (LS). [Additional Reference(s): DWR Levee Log, 1978, (HLM 0.86). USACE San Joaquin O&M Manual 612.2, 1967, (HLM 0.86)]. FS Date: 4/29/2021

LS view: Headwall visible at toe from crown.

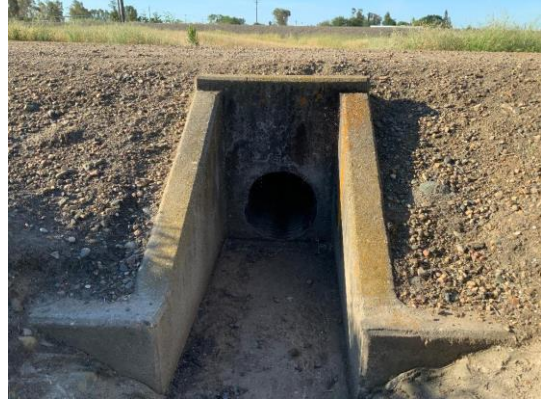
Photo 3 of 3 : UCIP_FA_2022_77598_97266.jpg

LS view: Slope and headwall at toe.

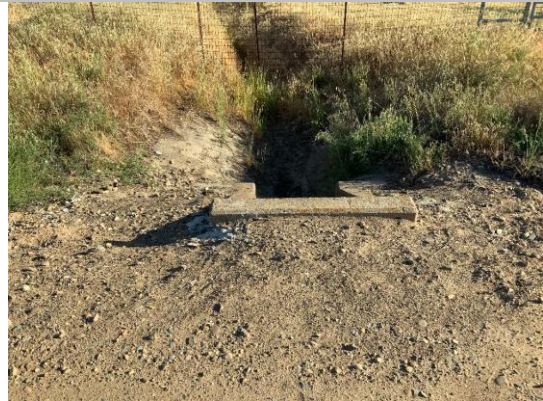
Photo 2 of 3 : UCIP_FA_2022_77599_97271.jpg

DS_ID:23866
FS_ID:77599
EP_NO: N/A
Repair Type: Non-Urgent
EVAL Issue:
Crossing Status: Found
UCIP Comments: 04/29/2021 The record has been upgraded from No Action Needed to Non-Urgent. DWR DMP internal inspection has not found pipe integrity issues. LOF of crossing is less or equal to 4.0. Recommend inspection in 5 years. No permit was found authorizing this encroachment. CVFPB will need to review crossing to determine owner. The UCIP inspection was completed with LMA representative, J. Nelson. (H. Dunn – GEI)
FIELD_STRUCT_DESC: 24-inch corrugated metal storm drainage pipe (CMP) through the levee, 5.0 feet below the crown. Flap gate on the waterside (WS) end. Concrete U-shaped headwalls on both ends. Cobble grouted spillway on the WS end. Cobble grouted intake on the landside (LS). [Additional Reference(s): DWR Levee Log, 1978, (HLM 1.09). USACE San Joaquin O&M Manual 612.2, 1967, (HLM 1.09)].
FS Date: 4/29/2021

LS view: Headwall visible at toe from crown.

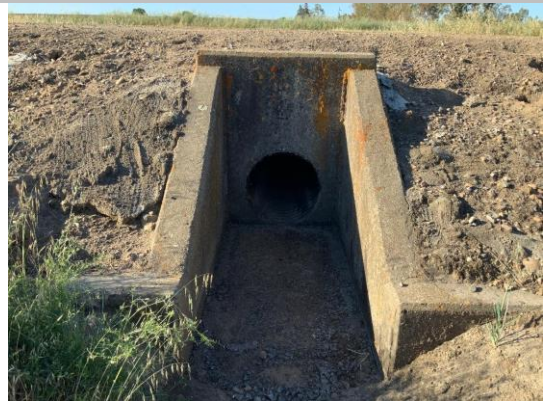
Photo 3 of 3 : UCIP_FA_2022_77599_97272.jpg

LS view: Slope and headwall at toe.

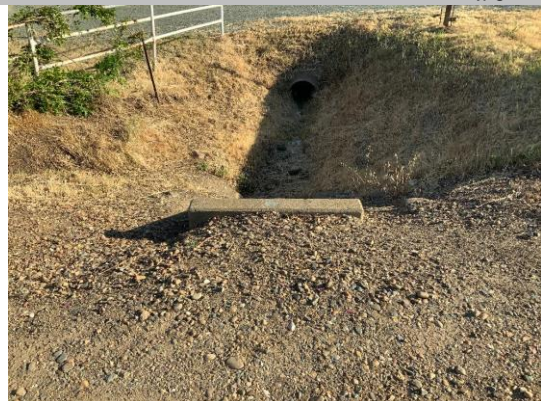
Photo 2 of 3 : UCIP_FA_2022_77600_97279.jpg

Comment Code						
Inspector Comment						
DS_ID:23867 FS_ID:77600 EP_NO: N/A Repair Type: Non-Urgent EVAL Issue: Crossing Status: Found UCIP Comments: 04/29/2021 The record has been upgraded from No Action Needed to Non-Urgent. DWR DMP internal inspection has not found pipe integrity issues. LOF of crossing is less or equal to 4.0. Recommend inspection in 5 years. No permit was found authorizing this encroachment. CVFPB will need to review crossing to determine owner. The UCIP inspection was completed with LMA representative, J. Nelson. (H. Dunn – GEI) FIELD_STRUCT_DESC: 24-inch corrugated metal storm drainage pipe (CMP) through the levee, 4.0 feet below the crown. Flap gate on the waterside (WS) end. Concrete U-shaped headwalls on both ends. Cobble grouted spillway on the WS end. Cobble grouted intake on the landside (LS). [Additional Reference(s): DWR Levee Log, 1978, (HLM 1.33). USACE San Joaquin O&M Manual 612.2, 1967, (HLM 1.33)]. FS Date: 4/29/2021

LS view: Headwall visible at toe from crown.

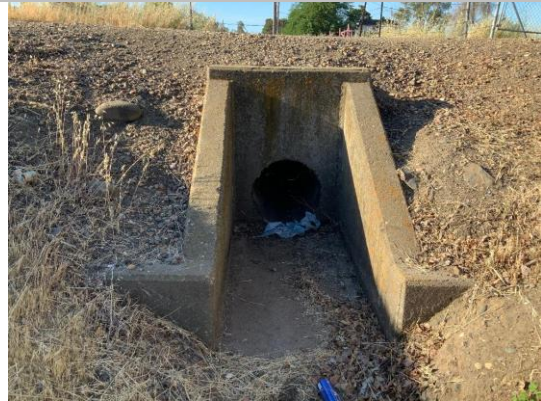
Photo 3 of 3 : UCIP_FA_2022_77600_97280.jpg

LS view: Slope and headwall at toe.

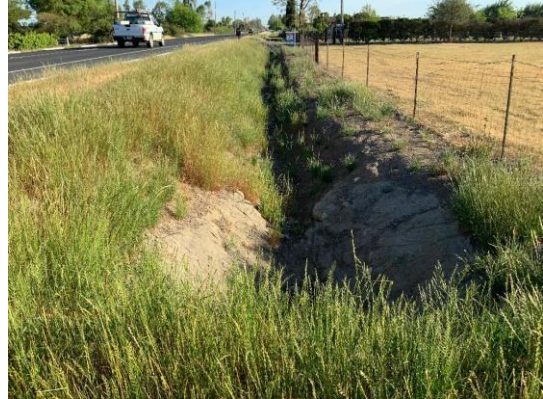
Photo 2 of 3 : UCIP_FA_2022_77601_97286.jpg

DS_ID:23868
 FS_ID:77601
 EP_NO: N/A
 Repair Type: Urgent
 EVAL Issue: 1, Pipe Integrity
 Crossing Status: Found
 UCIP Comments: 04/29/2021 Record has been upgraded from No Action Needed to Urgent. DWR DMP internal inspection has found pipe integrity issues. LOF of crossing is between 5 and 6. Crossing will be monitored until funding becomes available to address the issues. No permit was found authorizing this encroachment. CVFPB will need to review crossing to determine owner. The UCIP inspection was completed with LMA representative, J. Nelson. (H. Dunn ? GEI)04/28/2017 Crossing has been downgraded from Non-Urgent to No Action Needed, since sediment buildup is only minimal. (K. Fazel - UCIP)06/19/2014 Some sediment buildup in pipe at LS toe. (G. Wylie - FPIIB)
 FIELD_STRUCT_DESC: 30-inch corrugated metal storm drainage pipe (CMP) through the levee, 6.0 feet below the crown. Flap gate on the waterside (WS) end. Cobble grouted spillway on the WS end. Cobble grouted intake on the landside (LS). [Additional Reference(s): DWR Levee Log, 1978, (HLM 1.35). USACE San Joaquin O&M Manual 612.2, 1967, (HLM 1.35)].

LS view: Slope from crown.

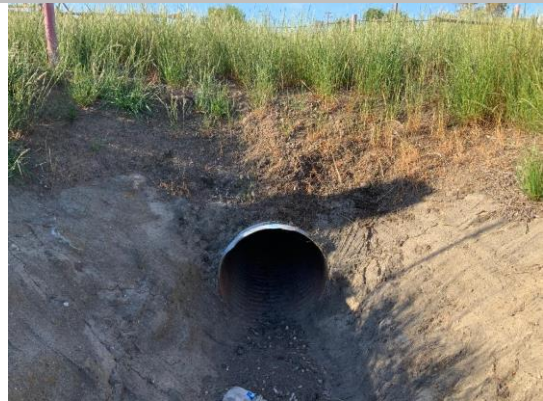
Photo 3 of 3 : UCIP_FA_2022_77601_97287.jpg

LS view: Slope and pipe inlet at toe.

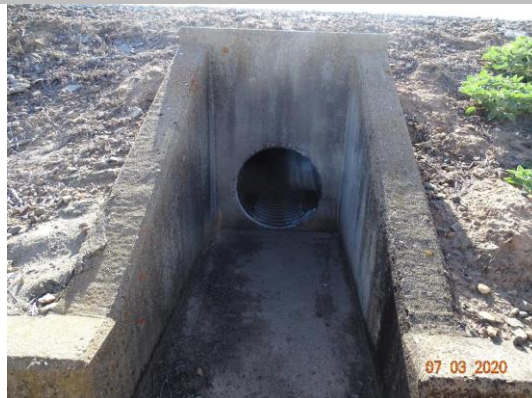
Photo 2 of 3 : UCIP_FA_2022_59640_86888.jpg

Comment Code						
Inspector Comment						
DS_ID:23880 FS_ID:59640 EP_NO: N/A Repair Type: Non-Urgent EVAL Issue: Crossing Status: Found UCIP Comments: 07/03/2020 Crossing evaluated as "Non-Urgent" because there was no permit found authorizing this pipe. (A. McDonald - DWR UCIP) FIELD_STRUCT_DESC: 24-inch corrugated metal drainage pipe through the levee, 5 feet below the crown. Concrete U-shaped headwall on both ends. Flap gate on the waterside (WS) end. Cobble grouted spillway. Cobble grouted intake on the landside (LS). [Additional Reference(s): DWR Levee Log, 1978, (HLM 0.16). USACE San Joaquin O&M Manual 612.2, 1967, (HLM 0.16)]. FS Date: 7/3/2020

Pipe inlet and headwall at LS levee toe.

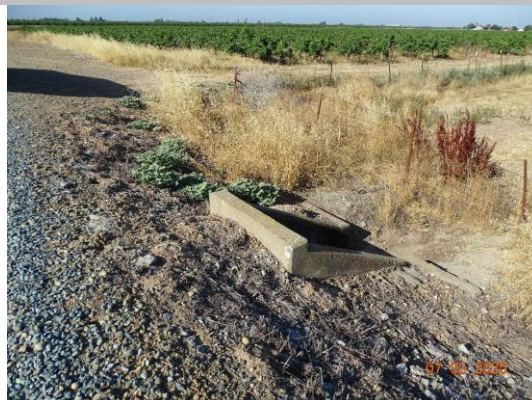
Photo 3 of 3 : UCIP_FA_2022_59640_86889.jpg

Pipe inlet, headwall, and flap gate at LS levee toe.

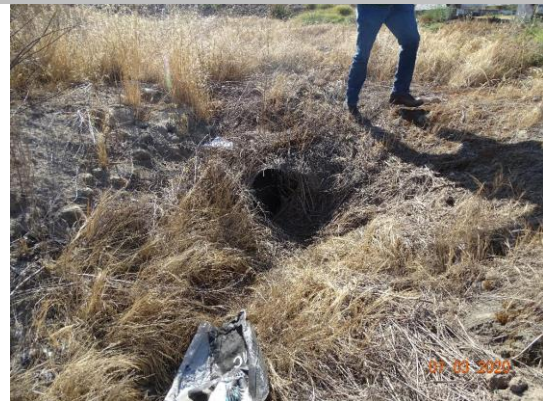
Photo 2 of 3 : UCIP_FA_2022_59641_86894.jpg

Comment Code					
Inspector Comment					
DS_ID:23881 FS_ID:59641 EP_NO: N/A Repair Type: Non-Urgent EVAL Issue: Crossing Status: Found UCIP Comments: 07/03/2020 Crossing evaluated as "Non-Urgent" because there was no permit found authorizing this pipe. (A. McDonald - DWR UCIP) 06/12/2014 Slide gate does not function properly up or down. (DWR UCIP) FIELD_STRUCT_DESC: 24-inch corrugated metal drainage pipe through the levee, 11 feet below the crown. Slide gate in 36-inch corrugated metal riser unit on the waterside (WS). Concrete U-shaped headwall on the WS end. Cobble grouted spillway. Cobble grouted intake on the landside (LS). [Additional Reference(s): DWR Levee Log, 1978, (HLM 0.47). USACE San Joaquin O&M Manual 612.2, 1967, (HLM 0.47)]. FS Date: 7/3/2020

Pipe inlet at the LS levee toe. No headwall.

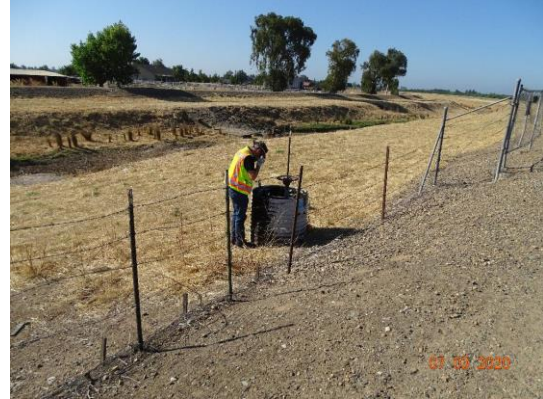
Photo 3 of 3 : UCIP_FA_2022_59641_86895.jpg

Riser and slide gate at the WS levee toe.

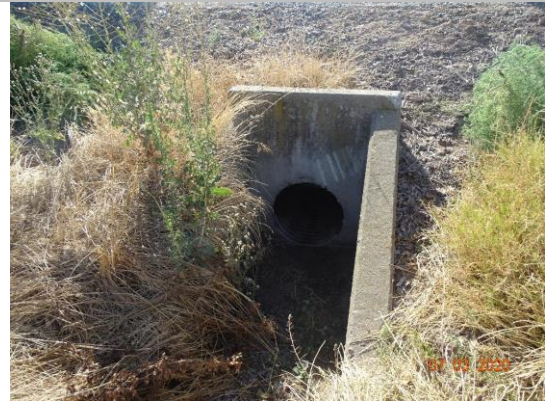
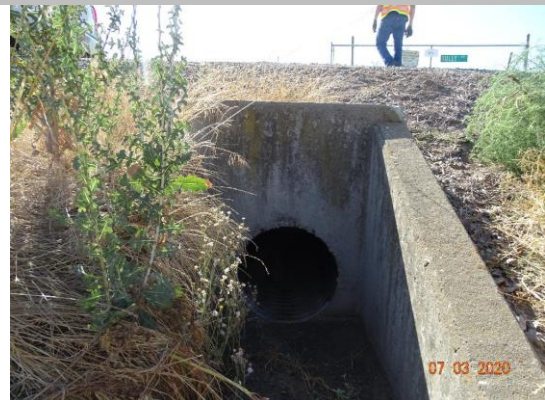
Photo 2 of 3 : UCIP_FA_2022_74838_86907.jpg

DS_ID:23882
 FS_ID:74838
 EP_NO: N/A
 Repair Type: Non-Urgent
 EVAL Issue: 5, Pipe Damage
 Crossing Status: Found
 UCIP Comments: 07/03/2020 Crossing evaluated as "Non-Urgent" because there was no permit found authorizing this pipe. Video inspection performed on 02/21/2020. (A. McDonald - DWR UCIP)
 FIELD_STRUCT_DESC: 24-inch corrugated metal drainage pipe through the levee, 7 feet below the crown. Concrete U-shaped headwall on both ends. Flap gate on the waterside (WS) end. Cobble grouted spillway. Cobble grouted intake on the landside (LS). [Additional Reference(s): DWR Levee Log, 1978, (HLM 0.50). USACE San Joaquin O&M Manual 612.2, 1967, (HLM 0.50)].
 FS Date: 7/3/2020

Pipe inlet and headwall at the LS levee toe.

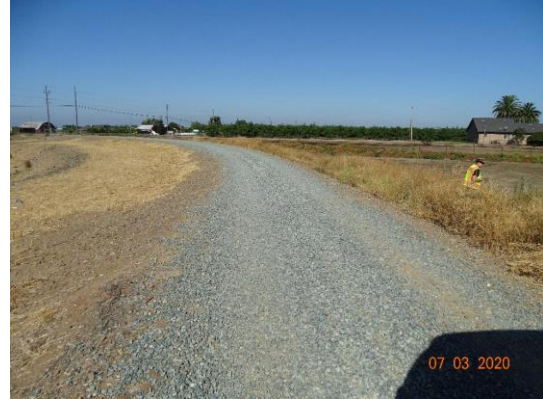
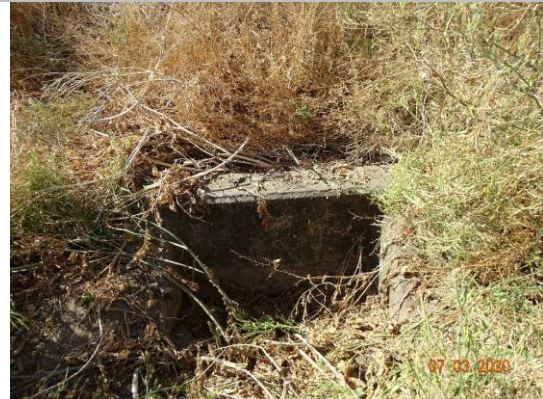
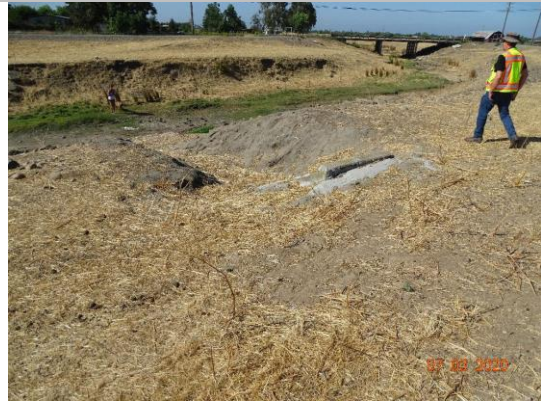
Photo 1 of 3 : UCIP_FA_2022_59643_86911.jpg

Comment Code					
Inspector Comment					
DS_ID:23883 FS_ID:59643 EP_NO: N/A Repair Type: Non-Urgent EVAL Issue: Crossing Status: Found UCIP Comments: 07/03/2020 Crossing evaluated as "Non-Urgent" because there was no permit found authorizing this pipe. Video inspection performed on 02-21-2020. (A. McDonald - DWR UCIP) 06/12/2014 Pipe filled in with soil on the LS toe and appears to be temporarily abandoned. (DWR UCIP) FIELD_STRUCT_DESC: 24-inch corrugated metal drainage pipe through the levee, 6.5 feet below the crown. Concrete U-shaped headwall on both ends. Flap gate on the waterside (WS) end. Cobble grouted spillway. Cobble grouted intake on the landside (LS). [Additional Reference(s): DWR Levee Log, 1978, (HLM 0.55). USACE San Joaquin O&M Manual 612.2, 1967, (HLM 0.55)]. FS Date: 7/3/2020

Pipe inlet and headwall at the LS levee toe.

Pipe outlet, headwall, and flap gate at the WS levee toe.

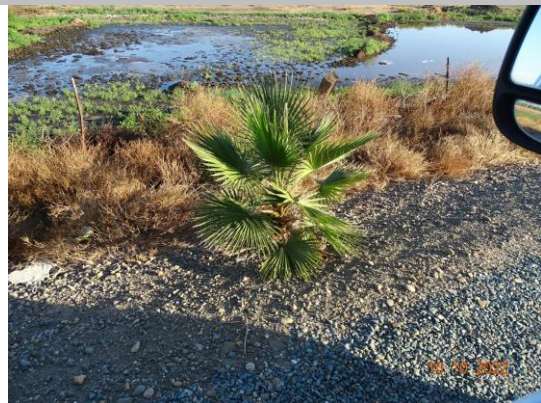
Photo 1 of 1 : FA_2022_NA0017_155_35_20221023_00102.jpg

LM Start	0.56	Rating **	M	Issue No.	35
LM End	0.56	Issue Type +	Ma	Location *	LS
Category	Earthen Levee			GPS Latitude/Longitude	
				Start	End
Item	Vegetation			38.102512 °	38.102512 °
				-121.167613 °	-121.167613 °
DWR ID	DWR_NA0017_11_f_2022_35				
Comment Code					
V2 : Remove the wild growth and woody vegetation other than native grasses from the levee slopes.					
Inspector Comment					
There is a palm tree growing on the landside slope.

View of Palm tree growing on the landside slope. Fall 2022

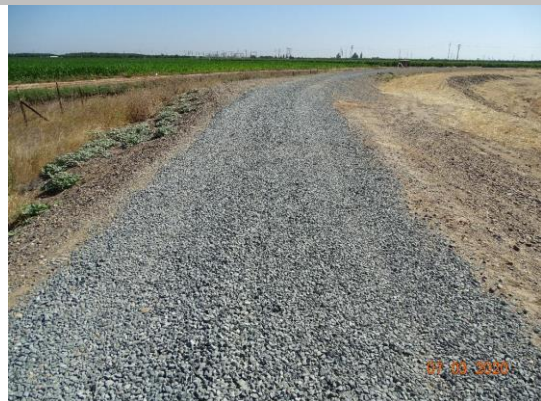
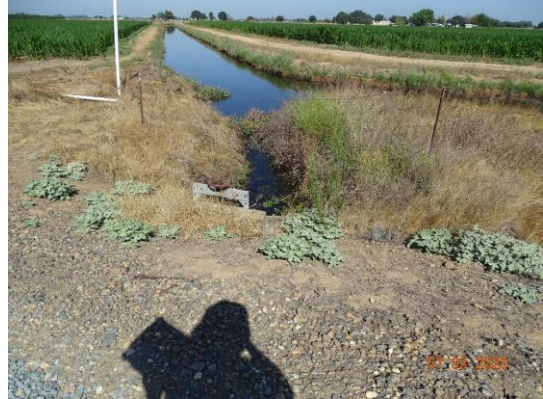
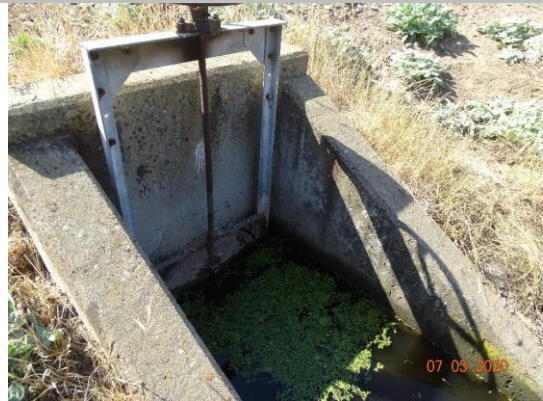
Photo 1 of 3 : UCIP_FA_2022_59645_86934.jpg

Comment Code					
Inspector Comment					
DS_ID:23885 FS_ID:59645 EP_NO: N/A Repair Type: Non-Urgent EVAL Issue: Crossing Status: Found UCIP Comments: 07/03/2020 Crossing evaluated as "Non-Urgent" because there was no permit found authorizing this pipe. Video inspection performed on 04-24-2020. (A. McDonald - DWR UCIP) FIELD_STRUCT_DESC: 24-inch corrugated metal drainage pipe through the levee, 6 feet below the crown. Concrete U-shaped headwall on both ends. Flap gate on the waterside (WS) end. Slide gate on the landside (LS) end. Cobble grouted spillway. Cobble grouted intake on the LS. [Additional Reference(s): DWR Levee Log, 1978, (HLM 1.07). USACE San Joaquin O&M Manual 612.2, 1967, (HLM 1.07)]. FS Date: 7/3/2020

View of pipe inlet, headwall, and slide gate at the LS levee toe.

Pipe inlet, headwall, and slide gate at the LS levee toe.

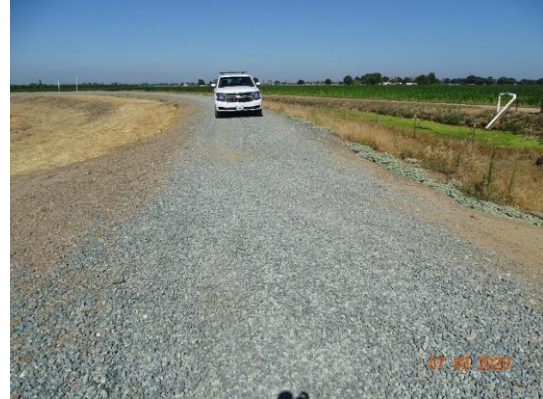
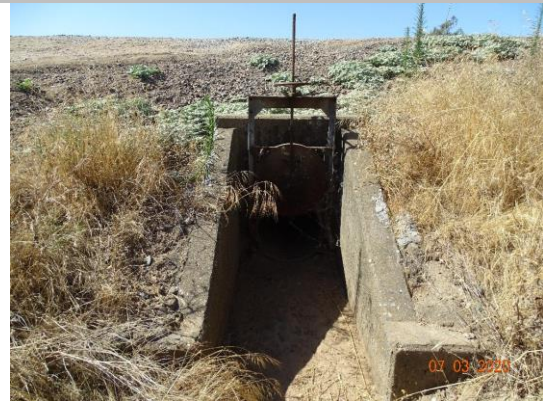
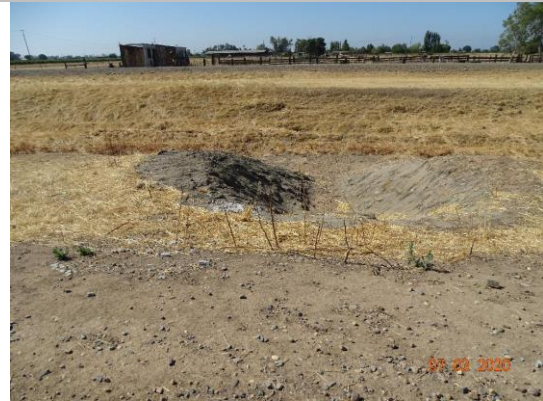
Photo 1 of 3 : UCIP_FA_2022_59646_86936.jpg

Comment Code						
Inspector Comment						
DS_ID:23870 FS_ID:59646 EP_NO: N/A Repair Type: Non-Urgent EVAL Issue: Crossing Status: Found UCIP Comments: 07/03/2020 Crossing evaluated as "Non-Urgent" because there was no permit found authorizing this pipe. (A. McDonald - DWR UCIP) FIELD_STRUCT_DESC: 24-inch corrugated metal drainage pipe through the levee, 8 feet below the crown. Concrete U-shaped headwall on both ends. Flap gate on the waterside (WS) end. Slide gate on the landside (LS) end. Two corrugated metal cutoff walls. Cobble grouted spillway. Cobble grouted intake on the LS. [Additional Reference(s): DWR Levee Log, 1978, (HLM 1.15). USACE San Joaquin O&M Manual 612.2, 1967, (HLM 1.15)]. FS Date: 7/3/2020

Pipe inlet, headwall, and slide gate at the LS levee toe.

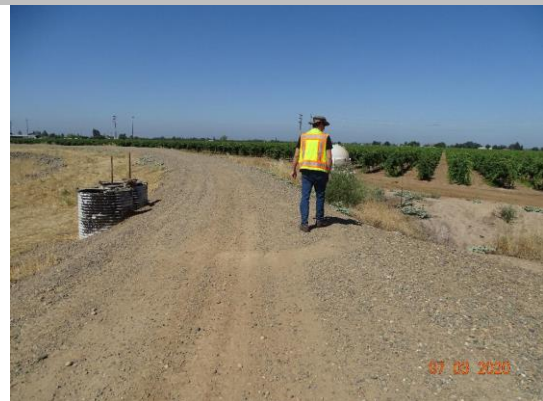
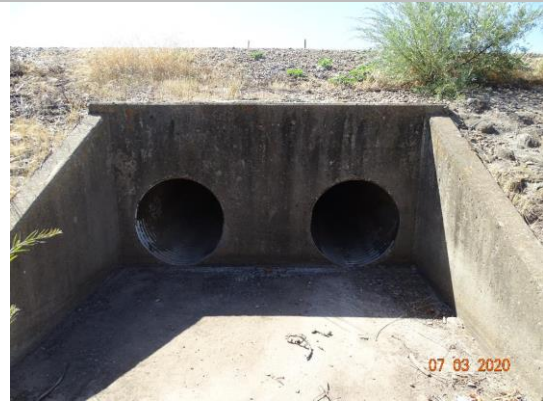
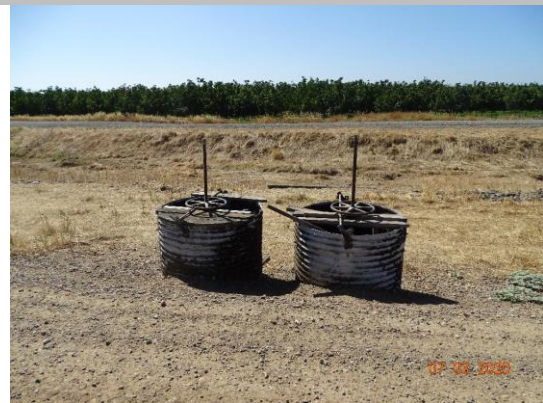
Photo 1 of 3 : UCIP_FA_2022_59647_86960.jpg

DS_ID:23871
 FS_ID:59647
 EP_NO: N/A
 Repair Type: Non-Urgent
 EVAL Issue:
 Crossing Status: Found
 UCIP Comments: 07/03/2020 Crossing evaluated as "Non-Urgent" because there was no permit found authorizing this pipe. (A. McDonald - DWR UCIP)
 06/12/2014 Slide gate may be rusted shut or does not function. Heavy sediment buildup in pipe. Lid on CMP riser needs repair. (DWR UCIP)
 FIELD_STRUCT_DESC: 1 of 2: 36-inch corrugated metal drainage pipe through the levee, 7 feet below the crown. Slide gate in 48-inch corrugated metal riser unit on the waterside (WS) slope. Concrete U-shaped headwall on both ends. Flap gate on the WS end. Cobble grouted spillway. Cobble grouted intake on the landside (LS).
 [Additional Reference(s): DWR Levee Log, 1978 (HLM 1.51). USACE San Joaquin O&M Manual 612.2, 1967, (HLM 1.51)].
 FS Date: 7/3/2020

Two pipe inlets and headwall at the LS levee toe.

Two slide gates and risers on the WS levee slope.

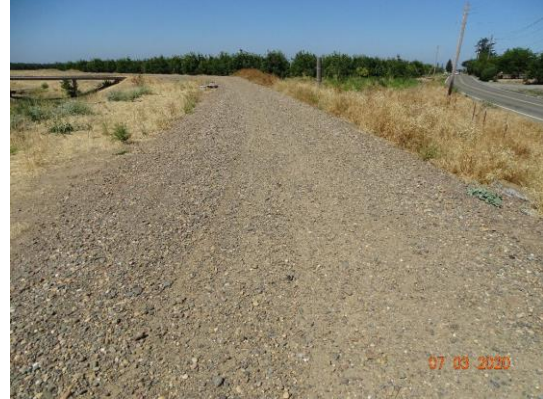
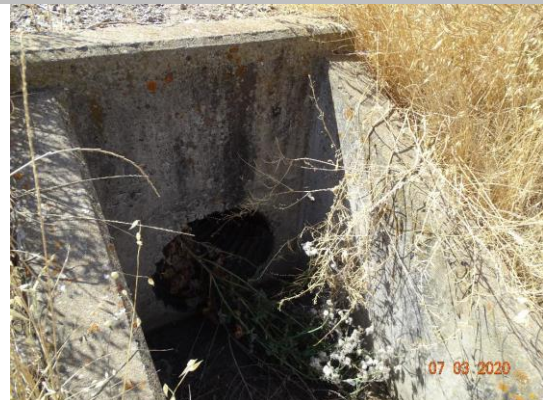
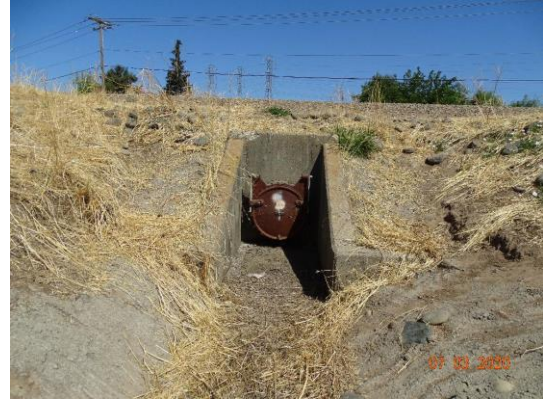
Photo 1 of 3 : UCIP_FA_2022_59651_86988.jpg

Comment Code					
Inspector Comment					
DS_ID:23874 FS_ID:59651 EP_NO: N/A Repair Type: Non-Urgent EVAL Issue: Crossing Status: Found UCIP Comments: 07/03/2020 Crossing evaluated as "Non-Urgent" because there was no permit found authorizing this pipe. (A. McDonald - DWR UCIP) FIELD_STRUCT_DESC: 24-inch corrugated metal drainage pipe through the levee, 6 feet below the crown. Concrete U-shaped headwall on both ends. Flap gate on the waterside (WS) end. Cobble grouted spillway. Cobble grouted intake on the landside (LS). [Additional Reference(s): DWR Levee Log, 1978, (HLM 2.05). USACE San Joaquin O&M Manual 612.2, 1967, (HLM 2.05)]. FS Date: 7/3/2020

Inlet pipe and headwall located at the LS levee toe.

Outlet pipe, flap gate, and headwall located at the WS levee toe.

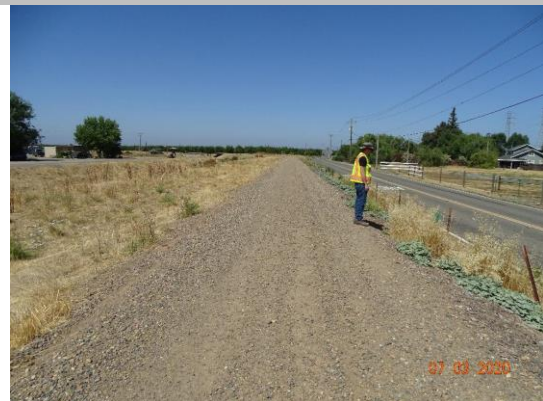
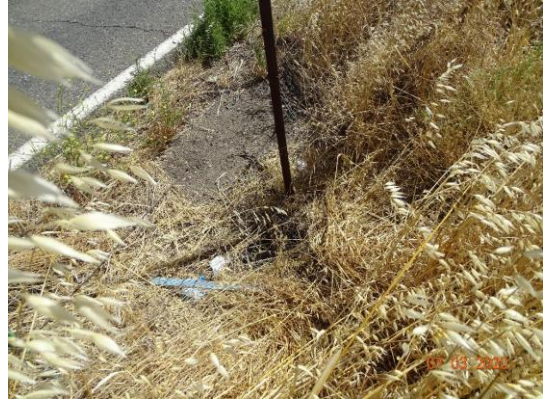
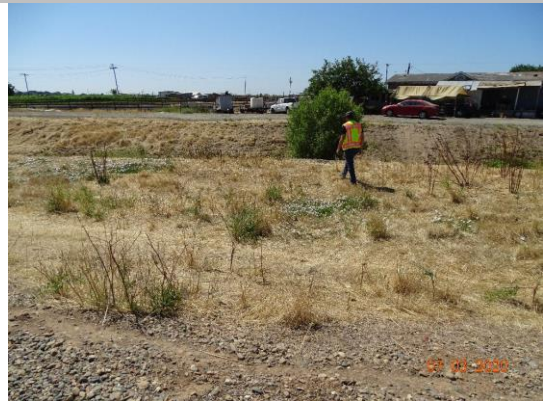
Photo 1 of 3 : UCIP_FA_2022_59652_86991.jpg

DS_ID:23875
 FS_ID:59652
 EP_NO: N/A
 Repair Type: Urgent
 EVAL Issue: 1, Pipe Integrity
 Crossing Status: Found
 UCIP Comments: 07/03/2020 Crossing evaluated as "Non-Urgent" because there was no permit found authorizing this pipe. Video inspection performed on 04-22-2020. (A. McDonald - DWR UCIP)
 FIELD_STRUCT_DESC: 12-inch corrugated metal drainage pipe through the levee, 5.5 feet below the crown. Flap gate on the waterside (WS) end. Drop inlet with grate at the landside (LS) toe. Spillway cobble grouted. [Additional Reference(s): DWR Levee Log, 1978, (HLM 2.14). USACE San Joaquin O&M Manual 612.2, 1967, (HLM 2.14)].
 FS Date: 7/3/2020

View of pipe inlet at the LS levee toe.

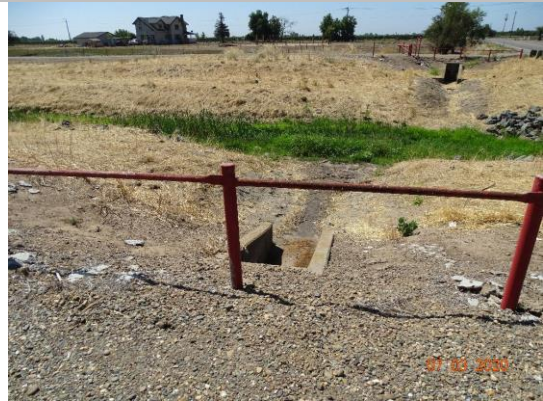
Photo 2 of 3 : UCIP_FA_2022_59656_87022.jpg

View of pipe outlet, WS channel, and opposite levee looking from the levee crown.

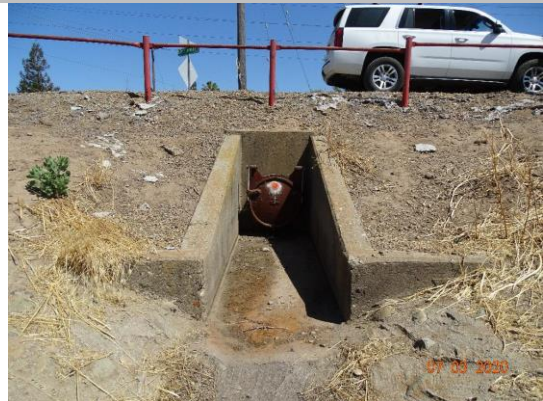
Photo 3 of 3 : UCIP_FA_2022_59656_87023.jpg

View of pipe outlet, flap gate, and headwall located at the WS levee toe.

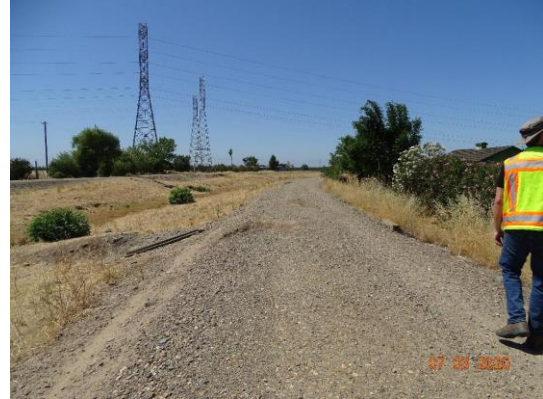
Photo 1 of 3 : UCIP_FA_2022_59658_87027.jpg

Comment Code					
Inspector Comment					
DS_ID:23886 FS_ID:59658 EP_NO: N/A Repair Type: Non-Urgent EVAL Issue: Crossing Status: Found UCIP Comments: 07/03/2020 Crossing evaluated as "Non-Urgent" because there was no permit found authorizing this pipe. (A. McDonald - DWR UCIP) FIELD_STRUCT_DESC: 24-inch corrugated metal drainage pipe through the levee, 4.5 feet below the crown. Concrete U-shaped headwall on both ends. Flap gate on the waterside (WS) end. Cobble grouted spillway. Cobble grouted intake on the landside (LS). [Additional Reference(s): DWR Levee Log, 1978, (HLM 2.44). USACE San Joaquin O&M Manual 612.2, 1967, (HLM 2.44)]. FS Date: 7/3/2020

Overview of levee crown looking d/s.

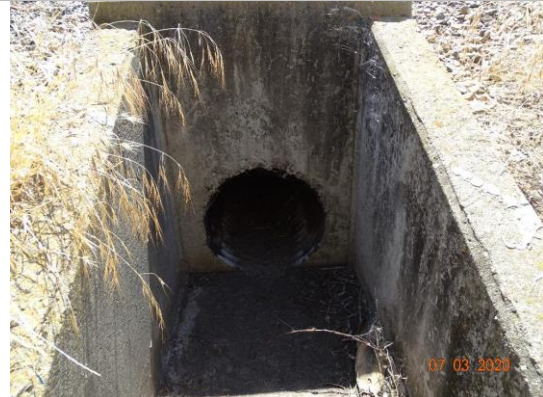
Photo 2 of 3 : UCIP_FA_2022_59658_87028.jpg

View of pipe inlet and headwall located at the LS levee toe.

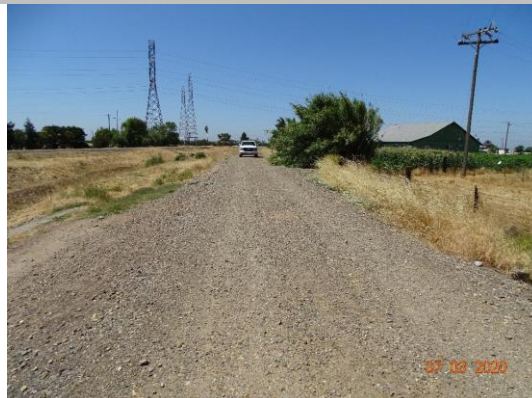
Photo 1 of 3 : UCIP_FA_2022_59659_87030.jpg

Comment Code					
Inspector Comment					
DS_ID:23887					
FS_ID:59659					
EP_NO: N/A					
Repair Type: Non-Urgent					
EVAL Issue:					
Crossing Status: Found					
UCIP Comments: 07/03/2020 Crossing evaluated as "Non-Urgent" because there was no permit found authorizing this pipe. (A. McDonald - DWR UCIP)					
FIELD_STRUCT_DESC: 24-inch corrugated metal drainage pipe through the levee, 5.5 feet below the crown. Concrete U-shaped headwall on both ends. Flap gate on the waterside (WS) end. Cobble grouted spillway. Cobble grouted intake on the landside (LS). [Additional Reference(s): DWR Levee Log, 1978, (HLM 2.48). USACE San Joaquin O&M Manual 612.2, 1967, (HLM 2.48)].					
FS Date: 7/3/2020

Overview of levee crown looking d/s.

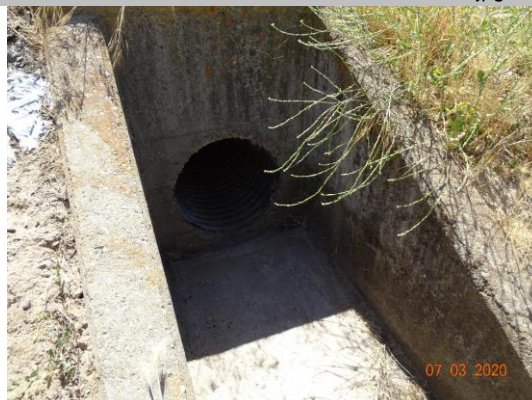
Photo 2 of 3 : UCIP_FA_2022_59659_87031.jpg

View of pipe inlet and headwall located at the LS levee toe.

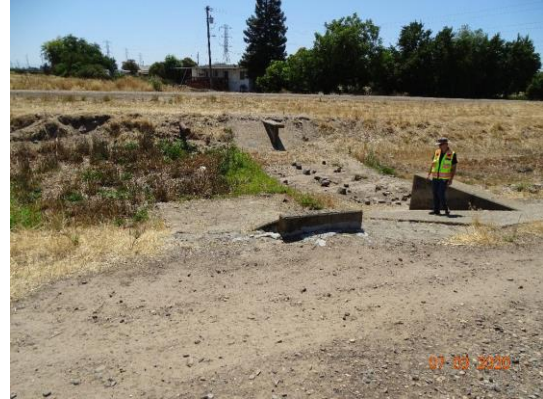
Photo 3 of 3 : UCIP_FA_2022_59659_87032.jpg

View of pipe outlet and channel located on the WS.

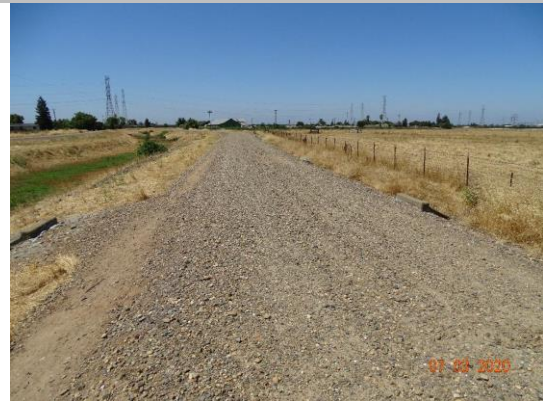
Photo 1 of 3 : UCIP_FA_2022_59660_87034.jpg

DS_ID:23888
 FS_ID:59660
 EP_NO: N/A
 Repair Type: Non-Urgent
 EVAL Issue:
 Crossing Status: Found
 UCIP Comments: 07/03/2020 Crossing evaluated as "Non-Urgent" because there was no permit found authorizing this pipe. Video inspection performed on 04-22-2020. (A. McDonald - DWR UCIP)
 FIELD_STRUCT_DESC: 24-inch corrugated metal drainage pipe through the levee, 6 feet below the crown. Concrete U-shaped headwall on both ends. Flap gate on the waterside (WS) end. Cobble grouted spillway. Cobble grouted intake on the landside (LS). [Additional Reference(s): DWR Levee Log, 1978, (HLM 2.58). USACE San Joaquin O&M Manual 612.2, 1967, (HLM 2.58)].
 FS Date: 7/3/2020

Overview of levee crown looking d/s.

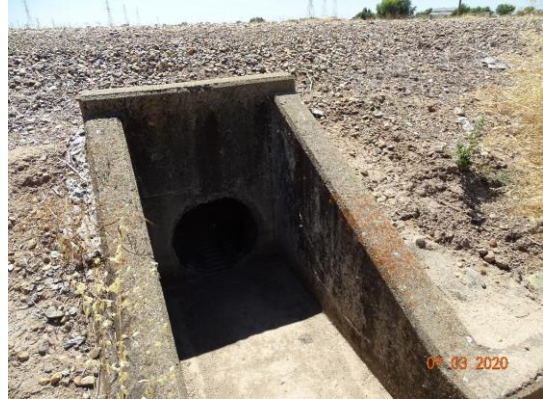
Photo 2 of 3 : UCIP_FA_2022_59660_87035.jpg

View of pipe inlet and headwall located at the LS levee toe.

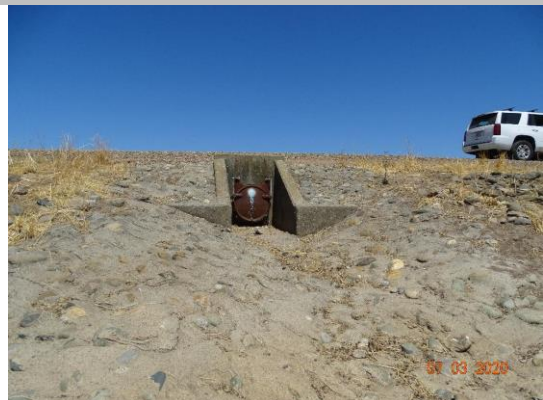
Photo 3 of 3 : UCIP_FA_2022_59660_87036.jpg

View of pipe outlet, flap gate, headwall, and splash apron located on the WS levee slope.

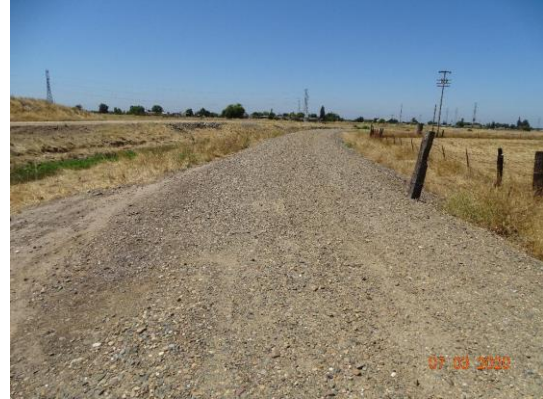
Photo 1 of 3 : UCIP_FA_2022_74839_87045.jpg

Comment Code					
Inspector Comment					
DS_ID:23890 FS_ID:74839 EP_NO: N/A Repair Type: Non-Urgent EVAL Issue: 5, Pipe Damage Crossing Status: Found UCIP Comments: 07/03/2020 Crossing evaluated as "No Action Needed." Permit and inspection requirements have been met. Video inspection performed on 04-22-2020. (A. McDonald - DWR UCIP) FIELD_STRUCT_DESC: 36-inch corrugated metal drainage pipe through the levee, 7 feet below the crown. Concrete U-shaped headwall on both ends. Flap gate on the waterside (WS) end. Cobble grouted spillway. Cobble grouted intake on the landside (LS). (Positive closure device installed on intake end under Permit No. 17426, 2003 - Western Dairy Design Associates, Inc.). [Additional Reference(s): DWR Levee Log, 1978, (HLM 2.73). USACE San Joaquin O&M Manual 612.2, 1967, (HLM 2.73)]. FS Date: 7/3/2020

Overview of levee crown looking d/s.

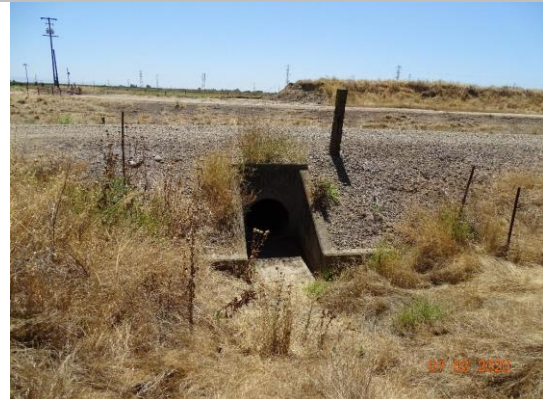
Photo 2 of 3 : UCIP_FA_2022_74839_87046.jpg

View of pipe inlet and headwall located at the LS levee toe.

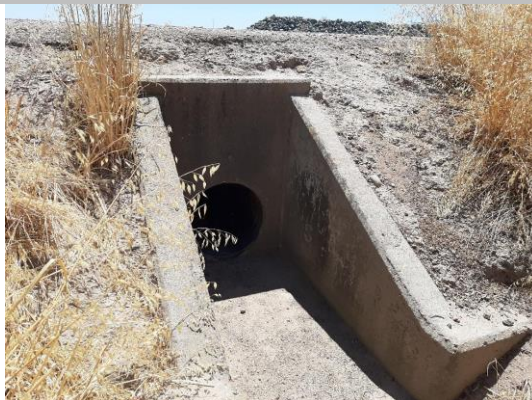
Photo 2 of 3 : UCIP_FA_2022_59663_87049.jpg

View of pipe inlet and headwall located at the LS levee toe.

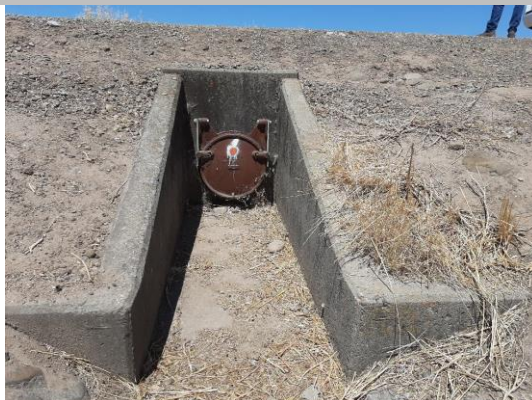
Photo 3 of 3 : UCIP_FA_2022_59663_87050.jpg

View of pipe outlet, flap gate, and headwall located at the WS levee toe.

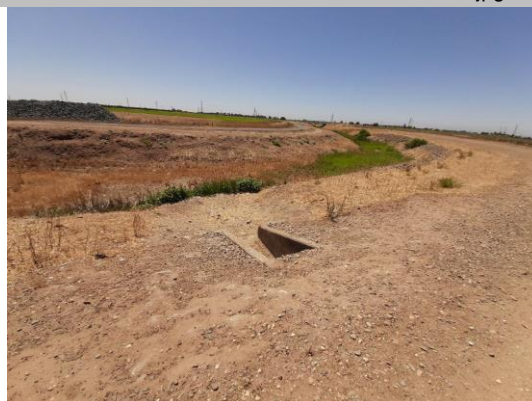
Photo 3 of 3 : UCIP_FA_2022_59665_87056.jpg

View of pipe outlet and WS channel.

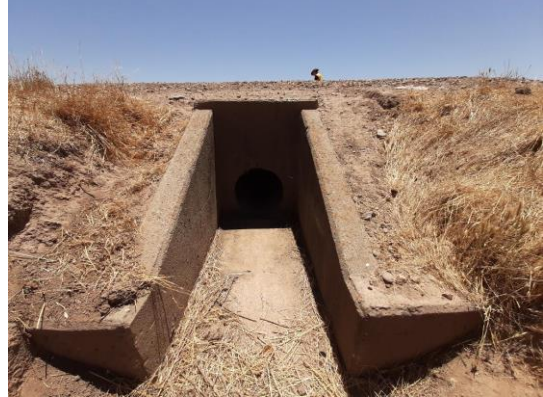
Photo 2 of 3 : UCIP_FA_2022_59666_87059.jpg

View of pipe inlet and headwall located at the LS levee toe.

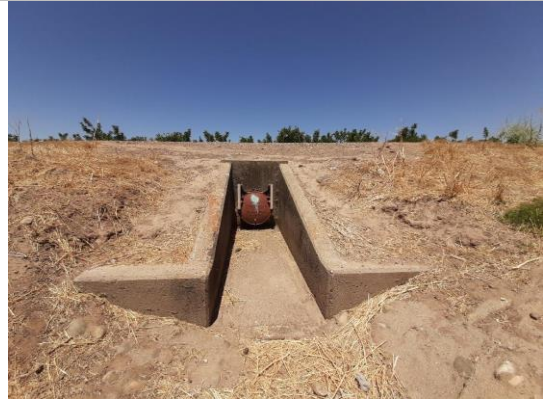
Photo 3 of 3 : UCIP_FA_2022_59666_87060.jpg

View of pipe outlet, flap gate, and headwall located at the WS levee toe.

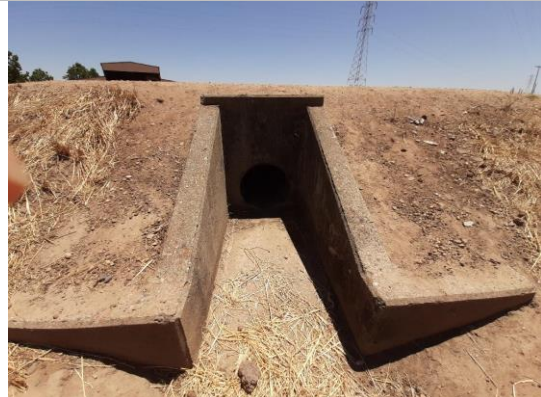
Photo 2 of 3 : UCIP_FA_2022_59668_87066.jpg

View of pipe inlet and headwall located at the LS levee toe.

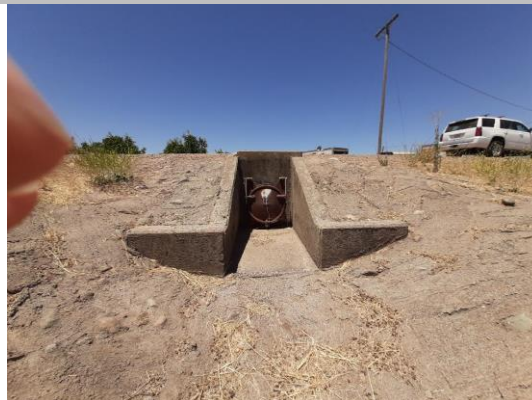
Photo 3 of 3 : UCIP_FA_2022_59668_87067.jpg

Comment Code					
Inspector Comment					
DS_ID:23895 FS_ID:59668 EP_NO: N/A Repair Type: Non-Urgent EVAL Issue: Crossing Status: Found UCIP Comments: 07/03/2020 Crossing evaluated as "Non-Urgent" because there was no permit found authorizing this pipe. (A. McDonald - DWR UCIP) FIELD_STRUCT_DESC: 24-inch corrugated metal drainage pipe through the levee, 5 feet below the crown. Concrete U-shaped headwall on both ends. Flap gate on the waterside (WS) end. Cobble grouted spillway. Cobble grouted intake on the landside (LS). [Additional Reference(s): DWR Levee Log, 1978, (HLM 3.47). USACE San Joaquin O&M Manual 612.2, 1967, (HLM 3.47)]. FS Date: 7/3/2020

View of pipe outlet, flap gate, and headwall located at the WS levee toe.

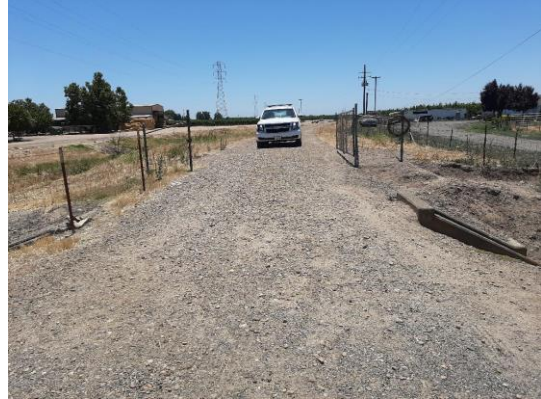
Photo 1 of 3 : UCIP_FA_2022_59669_87068.jpg

Comment Code					
Inspector Comment					
DS_ID:23896 FS_ID:59669 EP_NO: N/A Repair Type: Non-Urgent EVAL Issue: Crossing Status: Found UCIP Comments: 07/03/2020 Crossing evaluated as "Non-Urgent" because there was no permit found authorizing this pipe. Video inspection performed on 04-22-2020. (A. McDonald - DWR UCIP) FIELD_STRUCT_DESC: 24-inch corrugated metal drainage pipe through the levee, 4.5 feet below the crown. Concrete U-shaped headwall on both ends. Flap gate on the waterside (WS) end. Cobble grouted intake on the landside (LS). [Additional Reference(s): DWR Levee Log, 1978, (HLM 3.55). USACE San Joaquin O&M Manual 612.2, 1967, (HLM 3.55)]. FS Date: 7/3/2020

Overview of levee crown looking d/s.

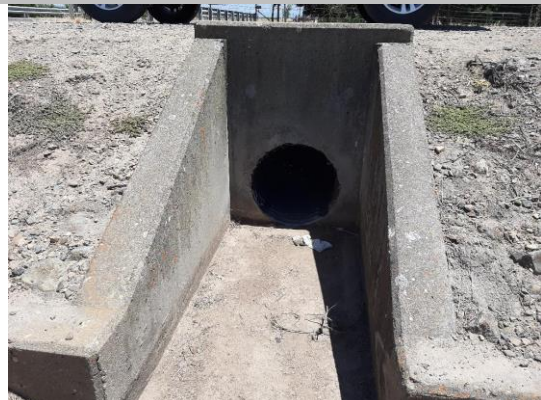
Photo 2 of 3 : UCIP_FA_2022_59669_87069.jpg

View of pipe inlet and headwall located at the LS levee toe.

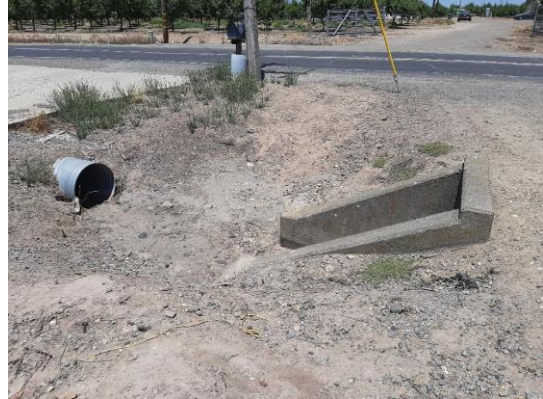
Photo 3 of 3 : UCIP_FA_2022_59669_87070.jpg

Drainage pipe under driveway leading to the inlet at the LS levee toe.

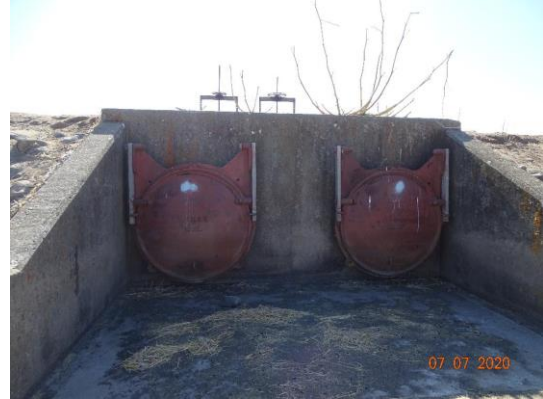
Photo 3 of 3 : UCIP_FA_2022_59601_87074.jpg

Comment Code						
Inspector Comment						
DS_ID:23925 FS_ID:59601 EP_NO: N/A Repair Type: Non-Urgent EVAL Issue: Crossing Status: Found UCIP Comments: 07/07/2020 Crossing evaluated as "Non-Urgent" because there was no permit found authorizing this pipe. Video inspection performed on 05-07-2020. (A. McDonald - DWR UCIP)Gate valve rusted in place. No lid or cover on Standpipe on WS slope. FIELD_STRUCT_DESC: 1 of 2: 42-inch corrugated metal drainage pipe through the levee, 7 feet below the crown. Slide gate in a 56-inch corrugated metal riser unit on the waterside (WS) slope. Flap gate on the WS end. Concrete headwall on both ends. [Additional Reference(s): DWR Levee Log, 1978, (HLM 0.14). USACE San Joaquin O&M Manual 612.2, 1967, (HLM 0.14) 36-inch pipe listed]. FS Date: 7/7/2020

Two pipe outlets, flap gates, and headwall located on the WS berm.

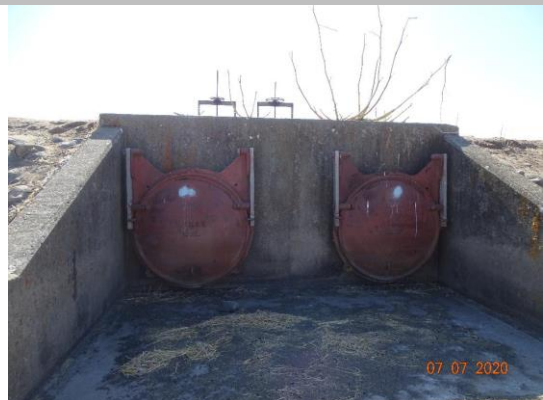
Photo 3 of 3 : UCIP_FA_2022_59602_87078.jpg

DS_ID:23930
 FS_ID:59602
 EP_NO: N/A
 Repair Type: Non-Urgent
 EVAL Issue:
 Crossing Status: Found
 UCIP Comments: 07/07/2020 Crossing evaluated as "Non-Urgent" because there was no permit found authorizing this pipe. (A. McDonald - DWR UCIP)
 06/12/2014 No lid on riser and slide gate actuator rusted in place. (DWR UCIP)
 FIELD_STRUCT_DESC: 2 of 2: 42-inch corrugated metal drainage pipe through the levee, 7 feet below the crown. Slide gate in 56-inch corrugated metal riser unit on the waterside (WS) slope. Flap gate on the WS end. [Additional Reference(s): DWR Levee Log, 1978, (HLM 0.14). USACE San Joaquin O&M Manual 612.2, 1967, (HLM 0.14) 36-inch pipe listed].
 FS Date: 7/7/2020

Two pipe outlets, flap gates, and headwall located on the WS berm.

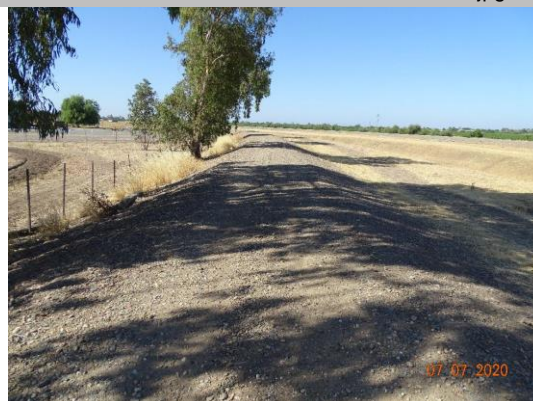
Photo 1 of 3 : UCIP_FA_2022_59603_87080.jpg

Comment Code					
Inspector Comment					
DS_ID:23900 FS_ID:59603 EP_NO: N/A Repair Type: Non-Urgent EVAL Issue: Crossing Status: Found UCIP Comments: 07/07/2020 Crossing evaluated as "Non-Urgent" because there was no permit found authorizing this pipe. (A. McDonald - DWR UCIP) FIELD_STRUCT_DESC: 24-inch corrugated metal drainage pipe through the levee, 6.5 feet below the crown. Concrete U-shaped headwall on both ends. Flap gate on the waterside (WS) end. Cobble grouted spillway. Cobble grouted intake on the landside (LS). [Additional Reference(s): DWR Levee Log, 1978, (HLM 0.40). USACE San Joaquin O&M Manual 612.2, 1967, (HLM 0.40)]. FS Date: 7/7/2020

Overview of levee crown looking d/s.

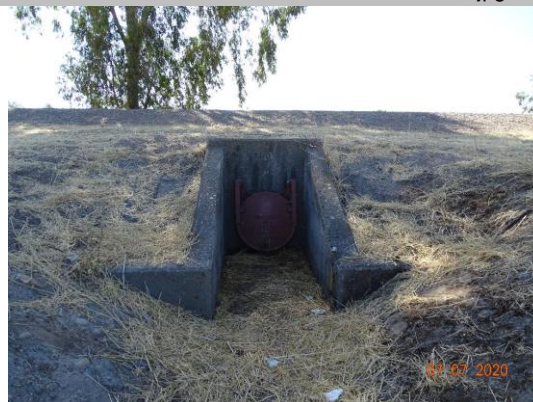
Photo 2 of 3 : UCIP_FA_2022_59603_87081.jpg

View of pipe outlet, flap gate, and headwall located on the WS berm.

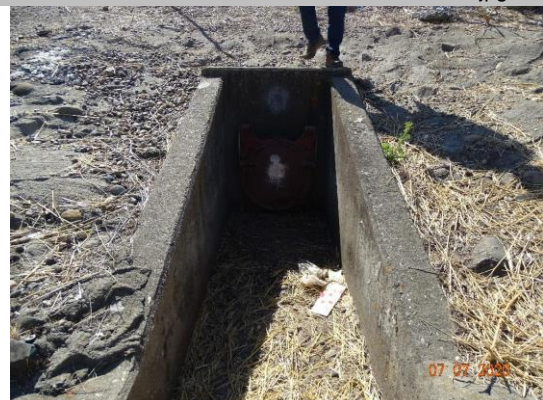
Photo 2 of 3 : UCIP_FA_2022_59605_87090.jpg

Comment Code						
Inspector Comment						
DS_ID:23901 FS_ID:59605 EP_NO: N/A Repair Type: Non-Urgent EVAL Issue: Crossing Status: Found UCIP Comments: 07/07/2020 Crossing evaluated as "Non-Urgent" because there was no permit found authorizing this pipe. (A. McDonald - DWR UCIP) FIELD_STRUCT_DESC: 24-inch corrugated metal drainage pipe through the levee, 7 feet below the crown. Concrete U-shaped headwall on both ends. Flap gate on the waterside (WS) end. Cobble grouted spillway. Cobble grouted intake on the landside (LS) end. [Additional Reference(s): DWR Levee Log, 1978, (HLM 0.48). USACE San Joaquin O&M Manual 612.2, 1967, (HLM 0.48)]. FS Date: 7/7/2020

View of pipe outlet, flap gate, and headwall located at the WS levee toe.

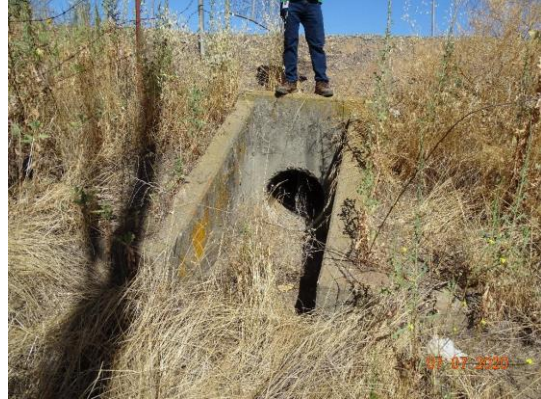
Photo 3 of 3 : UCIP_FA_2022_59605_87091.jpg

View of pipe inlet and headwall located at the LS levee toe.

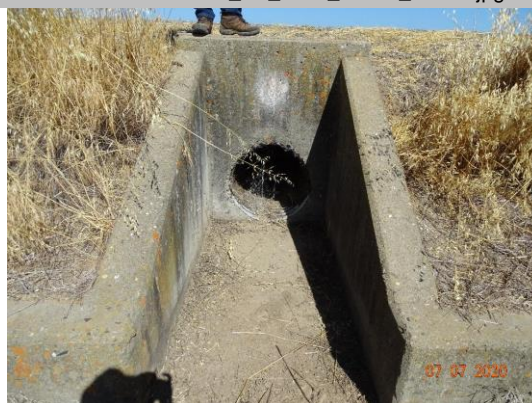
Photo 3 of 3 : UCIP_FA_2022_59606_87094.jpg

DS_ID:23902
 FS_ID:59606
 EP_NO: N/A
 Repair Type: Non-Urgent
 EVAL Issue:
 Crossing Status: Found
 UCIP Comments: 07/07/2020 Crossing evaluated as "Non-Urgent" because there was no permit found authorizing this pipe. (A. McDonald - DWR UCIP)
 FIELD_STRUCT_DESC: 24-inch corrugated metal drainage pipe through the levee, 4 feet below the crown. Concrete U-shaped headwall on both ends. Flap gate on the waterside (WS) end. Cobble grouted spillway. Cobble grouted intake on the landside (LS). [Additional Reference(s): DWR Levee Log, 1978, (HLM 0.61). USACE San Joaquin O&M Manual 612.2, 1967, (HLM 0.61)].
 FS Date: 7/7/2020

View of pipe inlet and headwall located at the LS levee toe.
