**Flood Control Project Maintenance
Levee Inspections**

Maintenance Issue Types Only, Levee Inspection Report By Mile - Fall 2022

San Joaquin County Flood Control and Water Conservation District

Waterway	Bank	Unit Miles	Inspection Start/End	Inspector
Unit No. 01 Littlejohn Creek	Left	2.59	10/13/2022 10/13/2022	Alberto De Leon

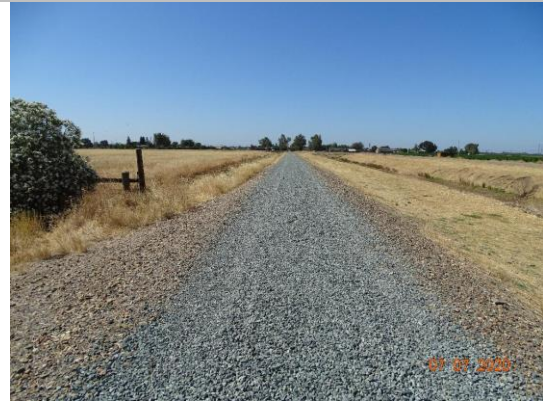
Photo 1 of 3 : UCIP_FA_2022_59607_87095.jpg

Comment Code						
Inspector Comment						
DS_ID:23903						
FS_ID:59607						
EP_NO: N/A						
Repair Type: Non-Urgent						
EVAL Issue:						
Crossing Status: Found						
UCIP Comments: 07/07/2020 Crossing evaluated as "Non-Urgent" because there was no permit found authorizing this pipe. Video inspection performed on 04-24-2020. (A. McDonald - DWR UCIP)						
FIELD_STRUCT_DESC: 24-inch corrugated metal drainage pipe through the levee, 5.5 feet below the crown. Concrete U-shaped headwalls on both ends. Flap gate on the waterside (WS) end. Cobble grouted spillway. Cobble grouted intake on the landside (LS) end. [Additional Reference(s): DWR Levee Log, 1978, (HLM 0.77). USACE San Joaquin O&M Manual 612.2, 1967, (HLM 0.77)].						
FS Date: 7/7/2020

Overview of levee crown looking d/s.

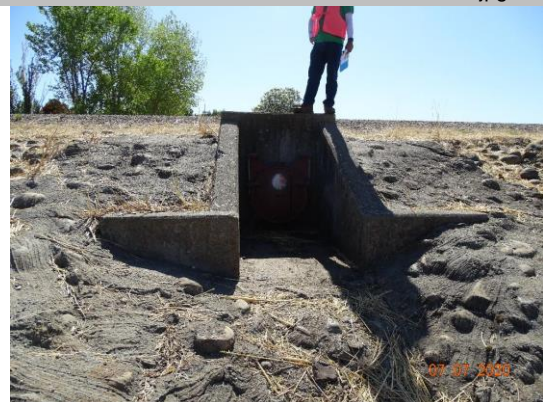
Photo 2 of 3 : UCIP_FA_2022_59607_87096.jpg

View of pipe outlet, flap gate, headwall, and splash apron located on the WS berm.

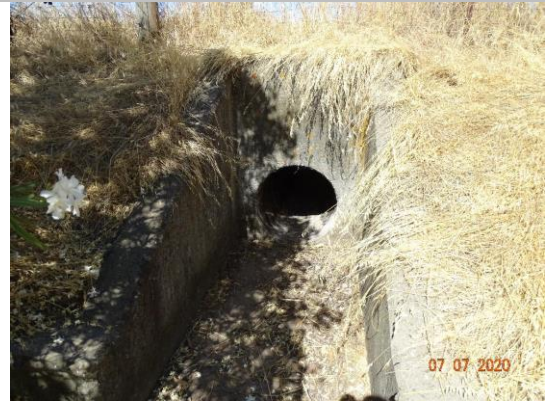
Photo 3 of 3 : UCIP_FA_2022_59607_87097.jpg

View of pipe inlet and headwall located at the LS levee toe.

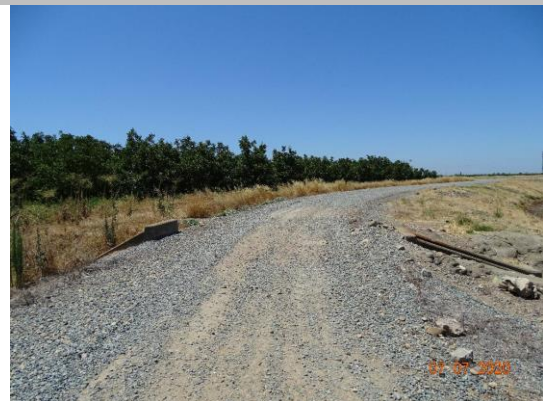
Photo 1 of 3 : UCIP_FA_2022_59608_87098.jpg

Comment Code						
Inspector Comment						
DS_ID:23904 FS_ID:59608 EP_NO: N/A Repair Type: Non-Urgent EVAL Issue: Crossing Status: Found UCIP Comments: 07/07/2020 Crossing evaluated as "Non-Urgent" because there was no permit found authorizing this pipe. (A. McDonald - DWR UCIP) FIELD_STRUCT_DESC: 24-inch corrugated metal drainage pipe through the levee, 2 feet below the crown. Concrete U-shaped headwalls on both ends. Flap gate on the waterside (WS) end. Cobble grouted spillway. Cobble grouted intake on the landside (LS). [Additional Reference(s): DWR Levee Log, 1978, (HLM 1.51). USACE San Joaquin O&M Manual 612.2, 1967, (HLM 1.51)]. FS Date: 7/7/2020

Overview of levee crown looking d/s.

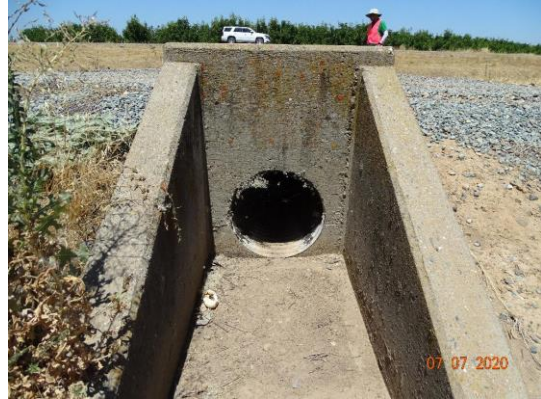
Photo 2 of 3 : UCIP_FA_2022_59608_87099.jpg

View of pipe inlet and headwall located at the LS levee toe.

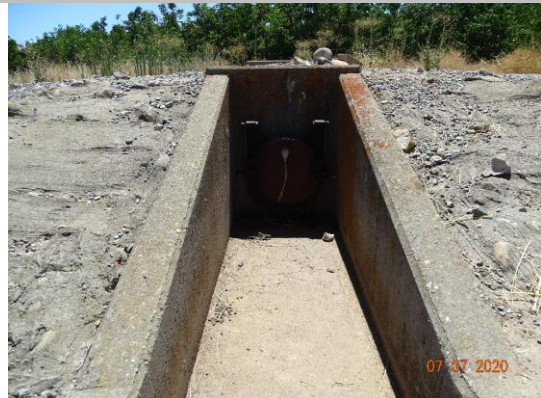
Photo 3 of 3 : UCIP_FA_2022_59608_87100.jpg

View of pipe outlet, flap gate, and headwall located on the WS berm.

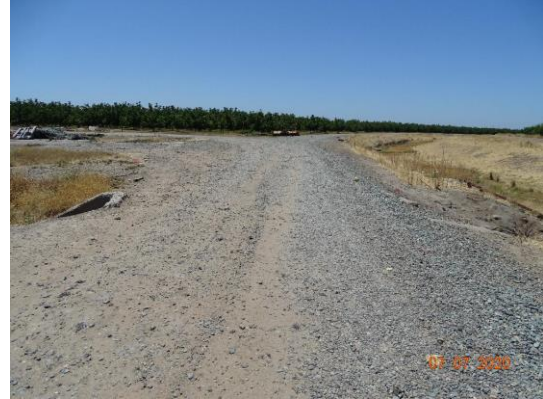
Photo 1 of 3 : UCIP_FA_2022_59609_87101.jpg

Comment Code						
Inspector Comment						
DS_ID:23905 FS_ID:59609 EP_NO: N/A Repair Type: Non-Urgent EVAL Issue: Crossing Status: Found UCIP Comments: 07/07/2020 Crossing evaluated as "Non-Urgent" because there was no permit found authorizing this pipe. Pipe inlet is clear of debris. (A. McDonald - DWR UCIP) 06/12/2014 Pipe is covered with soil at inlet on LS. (DWR UCIP) FIELD_STRUCT_DESC: 24-inch corrugated metal drainage pipe through the levee, 3.5 feet below the crown. Concrete U-shaped headwalls on both ends. Flap gate on the waterside (WS) end. Cobble grouted spillway. Cobble grouted intake on the landside (LS). [Additional Reference(s): DWR Levee Log, 1978, (HLM 1.90). USACE San Joaquin O&M Manual 612.2, 1967, (HLM 1.90)]. FS Date: 7/7/2020

Overview of levee crown looking d/s.

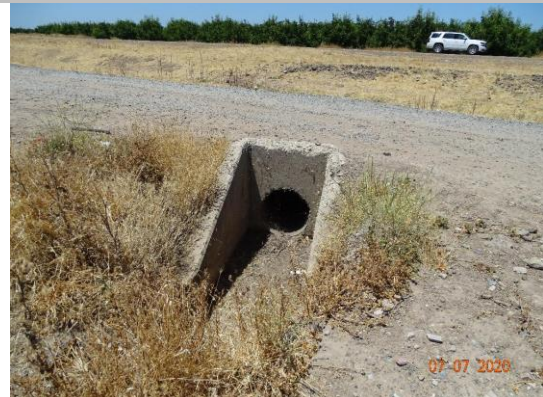
Photo 2 of 3 : UCIP_FA_2022_59609_87102.jpg

View of pipe inlet and headwall located at the LS levee toe.

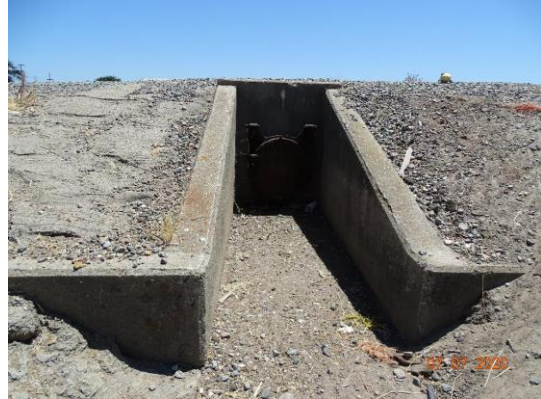
Photo 3 of 3 : UCIP_FA_2022_59609_87103.jpg

View of pipe outlet, flap gate, and headwall located at the WS levee toe.

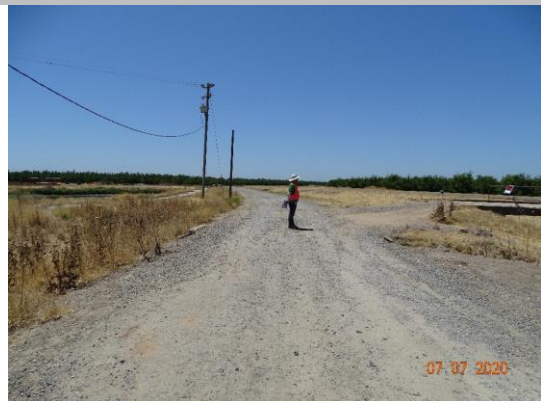
Photo 1 of 3 : UCIP_FA_2022_59610_87104.jpg

DS_ID:23906
 FS_ID:59610
 EP_NO: N/A
 Repair Type: Non-Urgent
 EVAL Issue:
 Crossing Status: Found
 UCIP Comments: 07/07/2020 Crossing evaluated as "Non-Urgent" because there was no permit found authorizing this pipe. Pipe no longer buried and not abandoned. Video inspection performed on 04-22-2020. (A. McDonald - DWR UCIP)
 06/12/2014 Pipe buried on both ends and appears to be abandoned. IF so, it should be done so properly. (DWR UCIP)
 FIELD_STRUCT_DESC: 24-inch corrugated metal drainage pipe through the levee, 4 feet below the crown. Concrete U-shaped headwall on both ends. Flap gate on the waterside (WS) end. Cobble grouted spillway. Cobble grouted intake on the landside (LS). [Additional Reference(s): DWR Levee Log, 1978, (HLM 1.96). USACE San Joaquin O&M Manual 612.2, 1967, (HLM 1.96)].
 FS Date: 7/7/2020

Overview of levee crown looking d/s.

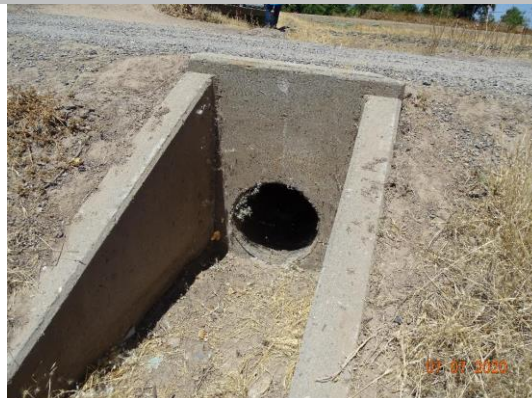
Photo 2 of 3 : UCIP_FA_2022_59610_87105.jpg

View of pipe inlet and headwall located at the LS levee toe.

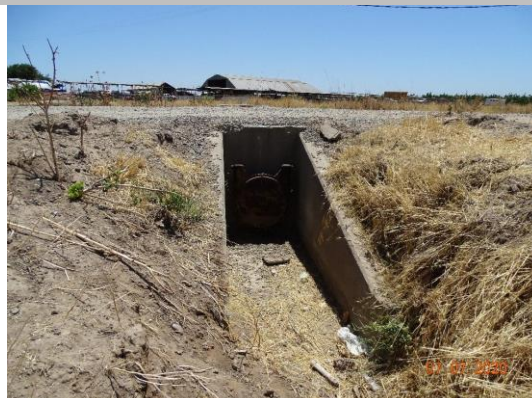
Photo 3 of 3 : UCIP_FA_2022_59610_87106.jpg

View of pipe outlet, flap gate, and headwall located at the WS levee toe.

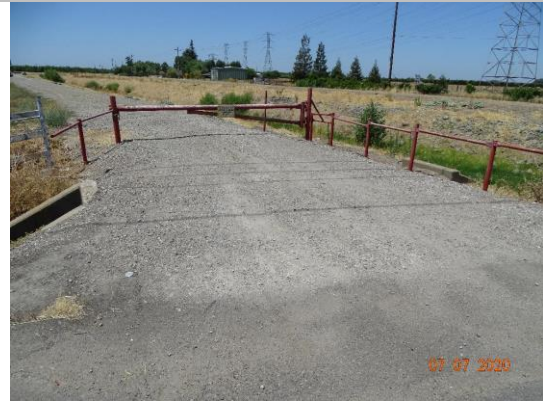
Photo 1 of 3 : UCIP_FA_2022_59613_87120.jpg

Comment Code					
Inspector Comment					
DS_ID:23908 FS_ID:59613 EP_NO: N/A Repair Type: Non-Urgent EVAL Issue: Crossing Status: Found UCIP Comments: 07/07/2020 Crossing evaluated as "Non-Urgent" because there was no permit found authorizing this pipe. Video inspection performed on 04-21-2020. (A. McDonald - DWR UCIP) FIELD_STRUCT_DESC: 24-inch corrugated metal drainage pipe through the levee, 4 feet below the crown. Concrete U-shaped headwalls on both ends. Flap gate on the waterside (WS) end. Cobble grouted spillway. Cobble grouted intake on the landside (LS). [Additional Reference(s): DWR Levee Log, 1978, (HLM 2.15). USACE San Joaquin O&M Manual 612.2, 1967, (HLM 2.15)]. FS Date: 7/7/2020

Overview of levee crown looking d/s.

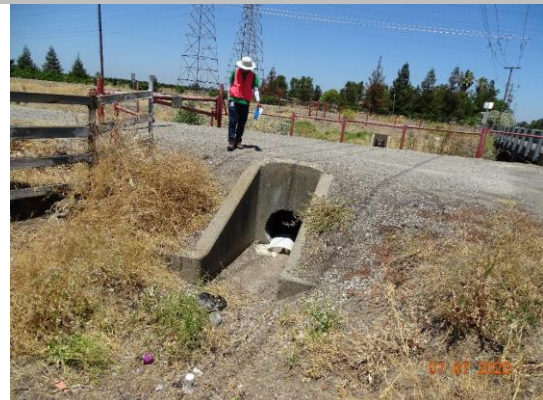
Photo 2 of 3 : UCIP_FA_2022_59613_87121.jpg

View of pipe inlet and headwall located at the LS levee toe.

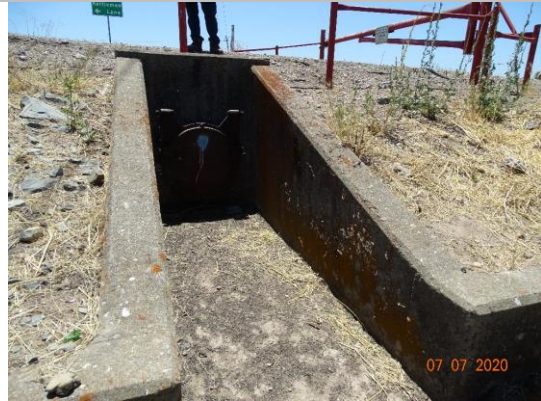
Photo 3 of 3 : UCIP_FA_2022_59613_87122.jpg

View of pipe outlet, flap gate, and headwall located at the WS levee toe.

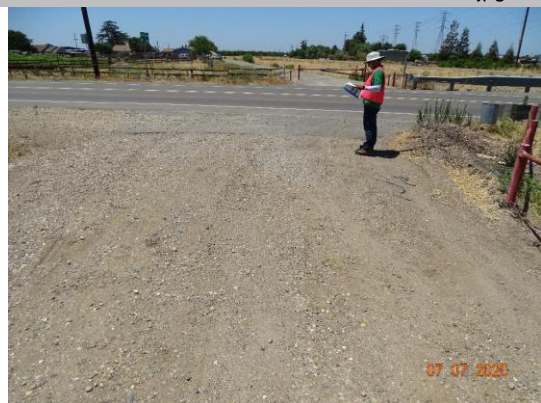
Photo 1 of 3 : UCIP_FA_2022_59617_87134.jpg

DS_ID:23909
 FS_ID:59617
 EP_NO: N/A
 Repair Type: Non-Urgent
 EVAL Issue:
 Crossing Status: Found
 UCIP Comments: 07/07/2020 Crossing evaluated as "Non-Urgent" because there was no permit found authorizing this pipe. (A. McDonald - DWR UCIP)
 FIELD_STRUCT_DESC: 24-inch corrugated metal drainage pipe through the levee, 5 feet below the crown. Concrete U-shaped headwalls on both ends. Flap gate on the waterside (WS) end. Cobble grouted spillway. Cobble grouted intake on the landside (LS).
 [Additional Reference(s): DWR Levee Log, 1978 (HLM 2.16). USACE San Joaquin O&M Manual 612.2, 1967, (HLM 2.16)].
 FS Date: 7/7/2020

Overview of levee crown looking d/s.

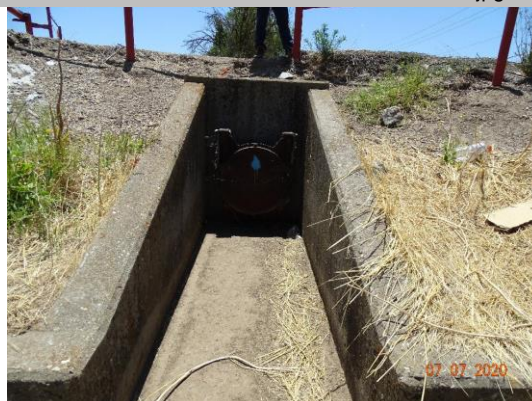
Photo 2 of 3 : UCIP_FA_2022_59617_87135.jpg

View of pipe outlet, flap gate, and headwall located at the WS levee toe.

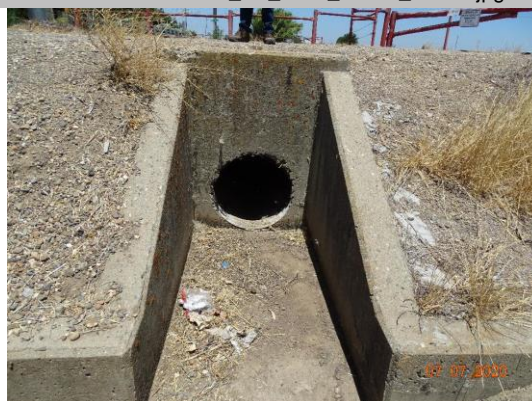
Photo 3 of 3 : UCIP_FA_2022_59617_87136.jpg

View of pipe inlet and headwall located at the LS levee toe.

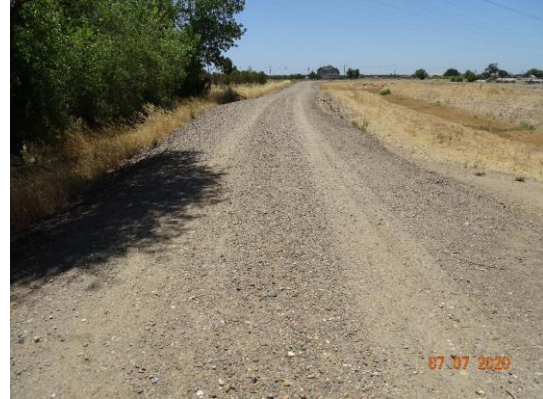
Photo 1 of 3 : UCIP_FA_2022_59624_87162.jpg

Comment Code					
Inspector Comment					
DS_ID:23911 FS_ID:59624 EP_NO: N/A Repair Type: Non-Urgent EVAL Issue: Crossing Status: Found UCIP Comments: 07/07/2020 Crossing evaluated as "Non-Urgent" because there was no permit found authorizing this pipe. (A. McDonald - DWR UCIP) FIELD_STRUCT_DESC: 24-inch corrugated metal drainage pipe through the levee, 6 feet below the crown. Concrete U-shaped headwalls on both ends. Flap gate on the waterside (WS) end. Cobble grouted spillway. Cobble grouted intake on the landside (LS). [Additional Reference(s): DWR Levee Log, 1978, (HLM 2.36). USACE San Joaquin O&M Manual 612.2, 1967, (HLM 2.36)]. FS Date: 7/7/2020

Overview of levee crown looking d/s.

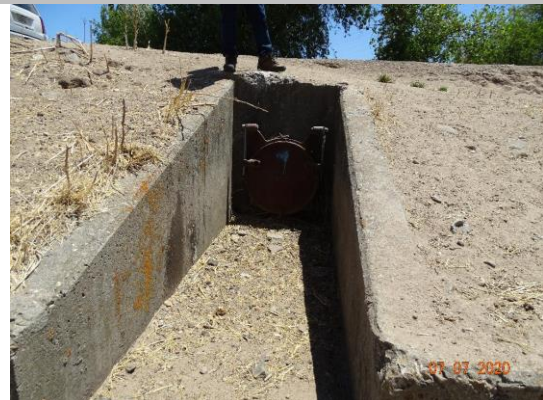
Photo 2 of 3 : UCIP_FA_2022_59624_87163.jpg

View of pipe outlet, flap gate, and headwall located at the WS levee toe.

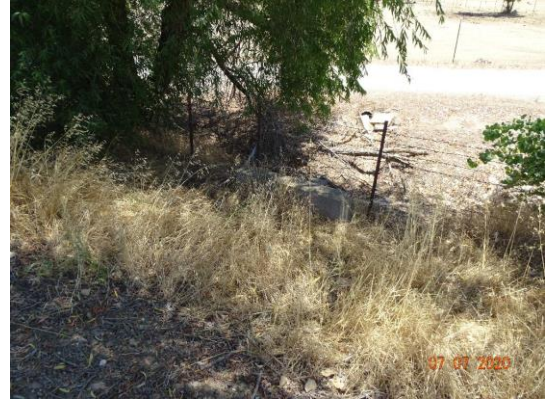
Photo 3 of 3 : UCIP_FA_2022_59624_87164.jpg

View of pipe inlet and headwall located at the LS levee toe.

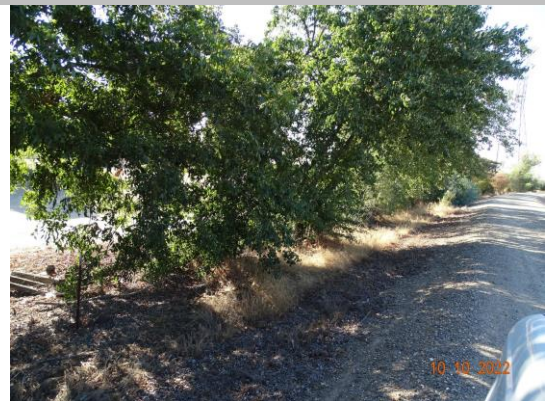
Photo 1 of 1 : FA_2022_NA0017_156_8_20221024_00093.jpg

LM Start	2.37	Rating **	M	Issue No.	8
LM End	2.41	Issue Type +	Ma	Location *	LS
Category	Earthen Levee			GPS Latitude/Longitude	
				Start	End
Item	Trim / Thin Trees			38.119141 °	38.119577 °
				-121.147713 °	-121.147504 °
DWR ID	DWR_NA0017_12_s_2012_8				
Comment Code					
T1 : Trim and thin trees to at least five feet above ground level to allow visibility of the ground and room to flood fight.					
Inspector Comment

View of untrimmed trees along the landside easement. Fall 2022

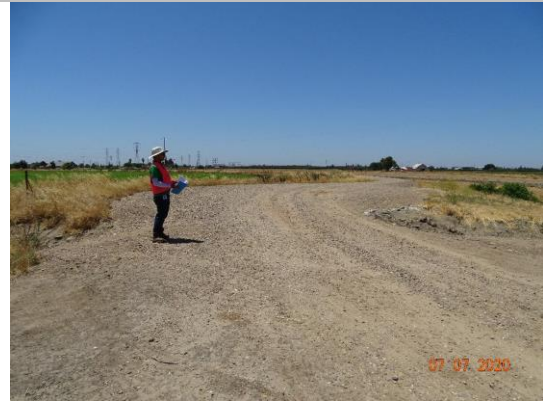
Photo 1 of 3 : UCIP_FA_2022_59626_87169.jpg

Comment Code						
Inspector Comment						
DS_ID:23913 FS_ID:59626 EP_NO: N/A Repair Type: Non-Urgent EVAL Issue: Crossing Status: Found UCIP Comments: 07/07/2020 Crossing evaluated as "Non-Urgent" because there was no permit found authorizing this pipe. (A. McDonald - DWR UCIP) 11/04/2016 Crossing has been downgraded from Urgent to Non-Urgent the silt buildup in front of the flap gate on the WS has been removed, however the sediment buildup inside the crossing still remains. Recommend clearing the sediment buildup inside the pipe and complete an internal integrity inspection to confirm crossing is in good condition. (O. Magana - DWR UCIP) 06/19/2014 Silt buildup on WS toe blocking flap gate operation. (W. Wylie - DWR UCIP) FIELD_STRUCT_DESC: 24-inch corrugated metal drainage pipe through the levee, 4 feet below the crown. Flap gate is located on the waterside (WS) end with a cobble grouted spillway. Cobble grouted intake on the landside (LS). [Additional Reference(s): DWR Levee Log, 1978, (HLM 2.61). USACE San Joaquin O&M Manual Unit 612.2, 1967, (HLM 2.61)]. FS Date: 7/7/2020

Overview of levee crown looking d/s.

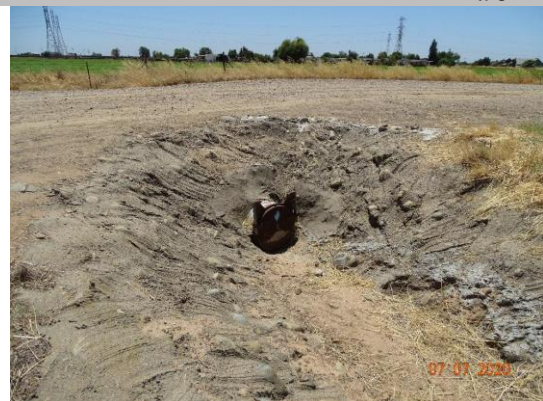
Photo 2 of 3 : UCIP_FA_2022_59626_87170.jpg

View of pipe outlet and spillway located at the WS levee toe.

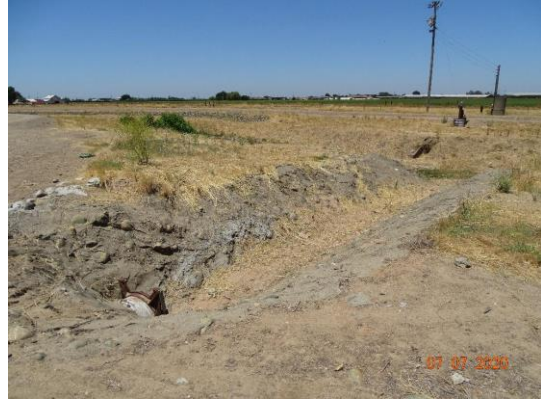
Photo 3 of 3 : UCIP_FA_2022_59626_87171.jpg

View of pipe outlet and spillway located at the WS levee toe.

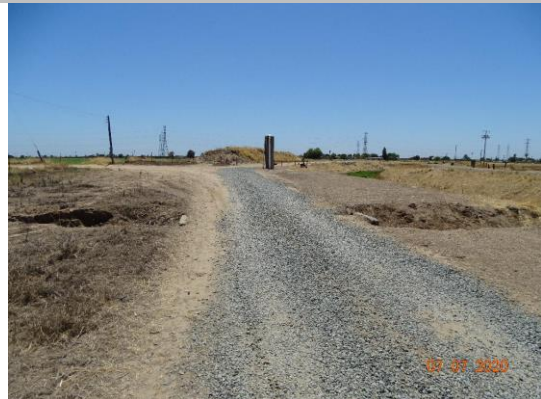
Photo 1 of 3 : UCIP_FA_2022_59630_87211.jpg

DS_ID:23915
 FS_ID:59630
 EP_NO: N/A
 Repair Type: Non-Urgent
 EVAL Issue:
 Crossing Status: Found
 UCIP Comments: 07/07/2020 Crossing evaluated as "Non-Urgent" because there was no permit found authorizing this pipe. Inlet partially blocked with sediment. (A. McDonald - DWR UCIP)
 FIELD_STRUCT_DESC: 12-inch corrugated metal drainage pipe through the levee, 2 feet below the crown. Flap gate on the waterside (WS) end. Cobble grouted spillway. Cobble grouted intake on the landside (LS). [Additional Reference(s): DWR Levee Log, 1978, (HLM 2.72). USACE San Joaquin O&M Manual 612.2, 1967, (HLM 2.72)].
 FS Date: 7/7/2020

Overview of levee crown looking d/s.

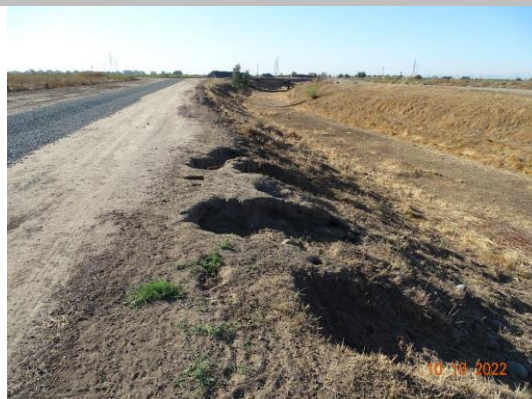
Photo 1 of 1 : FA_2022_NA0017_156_32_20221024_00092.jpg

LM Start	2.92	Rating **	M	Issue No.	32
LM End	2.92	Issue Type +	Ma	Location *	WS
Category	Earthen Levee			GPS Latitude/Longitude	
				Start	End
Item	Erosion / Bank Caving			38.125622 °	38.125622 °
				-121.143888 °	-121.143888 °
DWR ID	DWR_NA0017_12_s_2021_32				
Comment Code					
E2 : Schedule repair of erosion site prior to the next inspection.					
Inspector Comment					
This area is considered high ground. There is bank erosion near waterside hinge point, approximately 20 feet long, 12-18 inched deep and 3 feet wide.

View of erosion near the waterside hinge point. Fall 2022

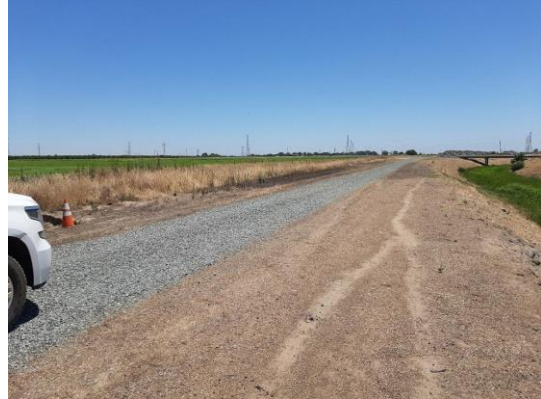
Photo 1 of 3 : UCIP_FA_2022_59632_87220.jpg

Comment Code						
Inspector Comment						
DS_ID:23916 FS_ID:59632 EP_NO: N/A Repair Type: No Action Needed EVAL Issue: Crossing Status: Found UCIP Comments: 07/03/2020 Crossing evaluated as "No Action Needed." Permit and inspection requirements have been met. (A. McDonald - DWR UCIP) FIELD_STRUCT_DESC: 12-inch corrugated metal drainage pipe through the levee, 3 feet below the crown. Flap gate on the waterside (WS) end. Cobble grouted spillway. (Positive closure device installed on intake end under Permit No. 17426, 2003 - Western Dairy Design Associates, Inc.). [Additional Reference(s): DWR Levee Log, 1978, (HLM 2.95). USACE San Joaquin O&M Manual 612.2, 1967, (HLM 2.95)]. FS Date: 7/3/2020

Overview of levee crown looking d/s.

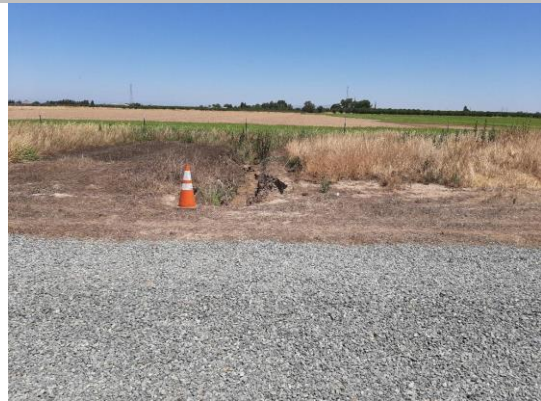
Photo 2 of 3 : UCIP_FA_2022_59632_87222.jpg

Overview of the LS and pipe inlet location.

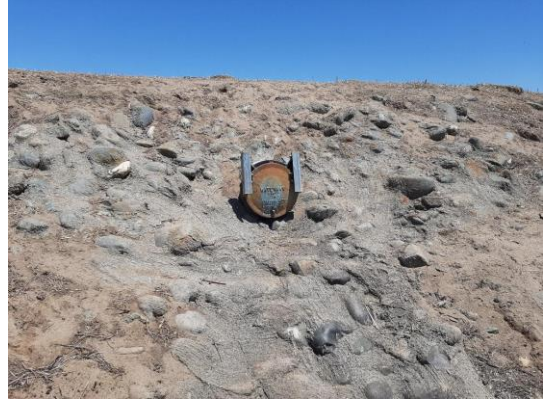
Photo 3 of 3 : UCIP_FA_2022_59632_87221.jpg

View of pipe outlet, flap gate, and splash apron located at the WS levee toe.

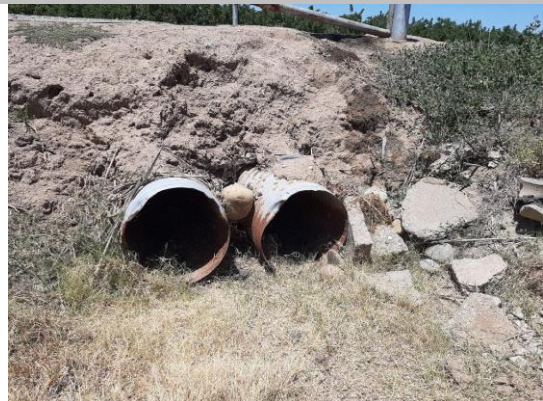
Photo 1 of 3 : UCIP_FA_2022_59674_87233.jpg

DS_ID:23928
FS_ID:59674
EP_NO: N/A
Repair Type: Urgent
EVAL Issue: 1, Pipe Integrity
Crossing Status: Found
UCIP Comments: 07/03/2020 Crossing evaluated as "Urgent" because of a badly deteriorated drainage pipe that is also open on both ends. There was no permit found authorizing this pipe, either. (A. McDonald - DWR UCIP)11/12/2018 NA0017 found corrosion and holes along the bottom of this CMP drainage culvert. Culvert is also open on both ends. Crossing escalated to "Urgent" due to the extensive corrosion that was found. Internal inspection and/or rehabilitation recommended. (A. McDonald - DWR UCIP)Pipe open on both ends.
FIELD_STRUCT_DESC: 1 of 2: 24-inch corrugated metal drainage pipe through the levee, 3 feet below the crown. No closure device or flap gate. [Additional Reference(s): USACE San Joaquin O&M Manual 612.2, 1967, (HLM 3.15)].
FS Date: 7/3/2020

View of two drainage pipe inlets located at the LS levee toe.

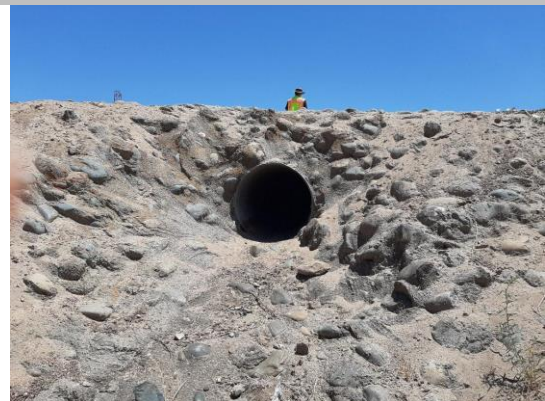
Photo 1 of 2 : UCIP_FA_2022_59676_87248.jpg

DS_ID:23917
 FS_ID:59676
 EP_NO: N/A
 Repair Type: Urgent
 EVAL Issue: 3a, Flood Risk
 Crossing Status: Found
 UCIP Comments: 07/03/2020 Crossing evaluated as "Urgent" because it is a straight-through drainage pipe with no flap gate on the WS end. There was also no permit found authorizing this pipe. (A. McDonald - DWR UCIP)
 06/19/2014 No flap gate. (DWR UCIP)
 FIELD_STRUCT_DESC: 24-inch corrugated metal drainage pipe through the levee, 4.5 feet below the crown. Cobble grouted spillway. Cobble grouted intake on the landside (LS). [Additional Reference(s): DWR Levee Log, 1978, (HLM 3.25). USACE San Joaquin O&M Manual 612.2, 1967, (HLM 3.25)].
 FS Date: 7/3/2020

View of pipe outlet and splash apron located at the WS levee toe.

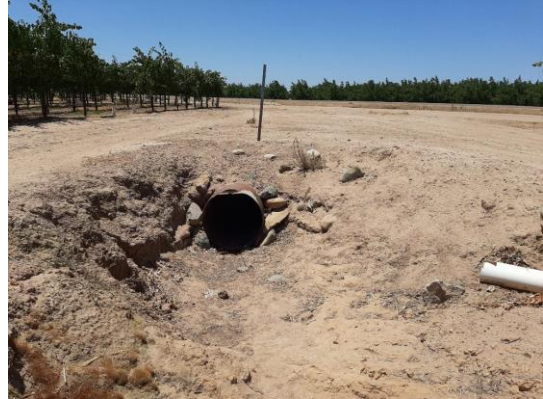
Photo 2 of 2 : UCIP_FA_2022_59676_87249.jpg

View of pipe inlet located 50 to 100 feet off the LS levee toe.

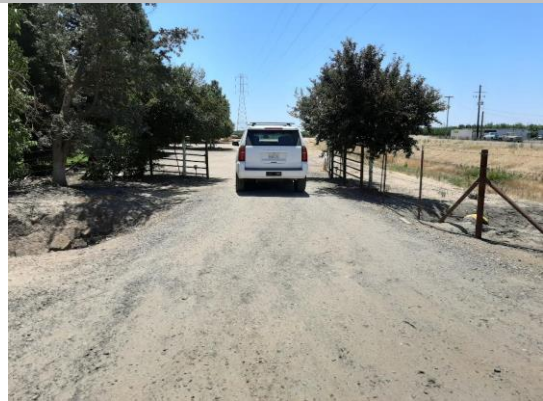
Photo 1 of 3 : UCIP_FA_2022_59638_87257.jpg

DS_ID:23920
 FS_ID:59638
 EP_NO: N/A
 Repair Type: Urgent
 EVAL Issue: 1, Pipe Integrity
 Crossing Status: Found
 UCIP Comments: 07/03/2020 Crossing evaluated as "Non-Urgent" because there was no permit found authorizing this pipe. Video inspection performed on 04-22-2020. (A. McDonald - DWR UCIP)
 FIELD_STRUCT_DESC: 12-inch corrugated metal drainage pipe through the levee, 4.5 feet below the crown. Cobble grouted spillway.
 [Additional Reference(s): DWR Levee Log, 1978, (HLM 3.52). USACE San Joaquin O&M Manual 612.2, 1967, (HLM 3.52)].
 FS Date: 7/3/2020

Overview of levee crown looking d/s.

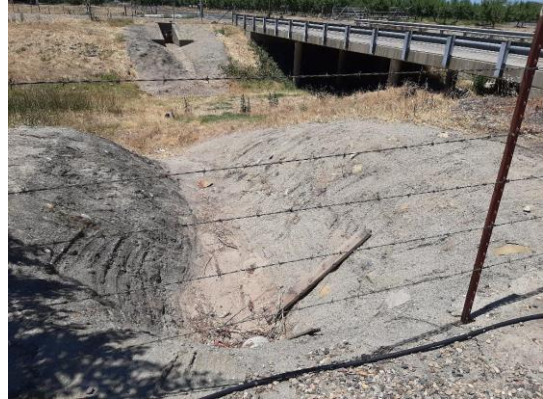
Photo 2 of 3 : UCIP_FA_2022_59638_87258.jpg

View of WS channel and splash apron.

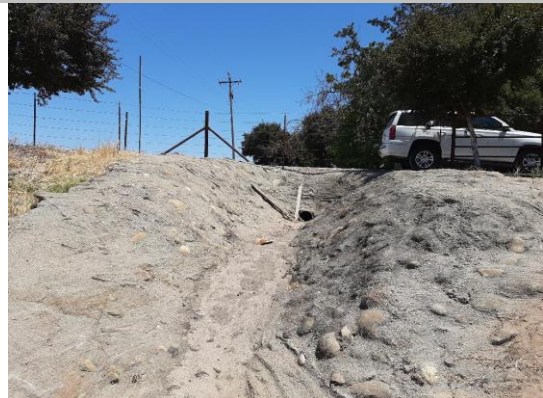
Photo 3 of 3 : UCIP_FA_2022_59638_87259.jpg

View of pipe outlet and splash apron located at the WS levee toe.

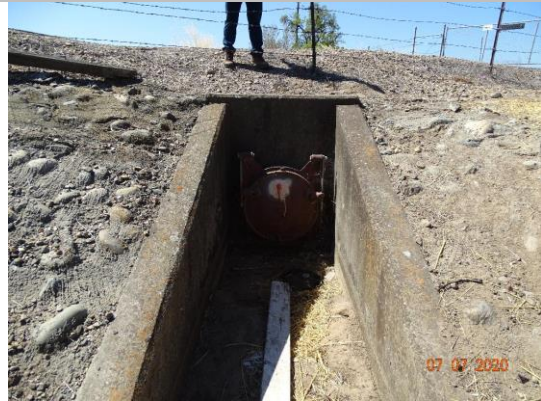
Photo 1 of 1 : UCIP_FA_2022_58902_86735.jpg

Comment Code					
Inspector Comment					
DS_ID:23933 FS_ID:58902 EP_NO: N/A Repair Type: Non-Urgent EVAL Issue: Crossing Status: Found UCIP Comments: 07/07/2020 Record updated from No Action Needed to Non-Urgent. No permit has been identified authorizing pipe. Pipe was in good condition, same as last inspection. Internal video Inspection was performed on 2/21/2020 (S.Donovan - DWR UCIP) FIELD_STRUCT_DESC: 24-inch corrugated metal drainage pipe through the levee, 5 feet below the crown. Concrete U-shaped headwall on both ends. Flap gate on the waterside (WS) end. Cobble grouted spillway. Cobble grouted intake on the landside (LS). [Additional Reference(s): DWR Levee Log, 1978. USACE San Joaquin O&M Manual 612.2, 1967, (HLM 0.58)]. FS Date: 7/7/2020 1:09:28 PM

Water-Side: View of pipe, headwall and flapgate.

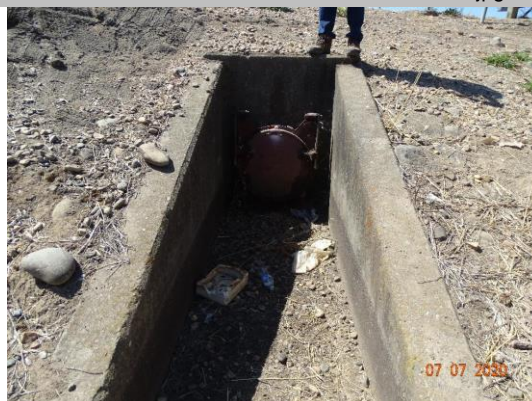
Photo 1 of 1 : UCIP_FA_2022_58905_86744.jpg

Comment Code						
Inspector Comment						
DS_ID:23934 FS_ID:58905 EP_NO: N/A Repair Type: Non-Urgent EVAL Issue: Crossing Status: Found UCIP Comments: 07/07/2020 Record updated from No Action Needed to Non Urgent. No permit has been identified authorizing pipe. This is a system feature with no modification to the system. Pipe is in good condition. Same observation as last inspection. Internal video inspection was performed in 4/24/2020. (S.Donovan - DWR UCIP) FIELD_STRUCT_DESC: 24-inch corrugated metal drainage pipe through the levee, 5 feet below the crown. Concrete U-shaped headwall on both ends. Flap gate on the waterside (WS) end. Cobble grouted spillway. Cobble grouted intake on the landside (LS). [Additional Reference(s): DWR Levee Log, 1978. USACE San Joaquin O&M Manual 612.2, 1967, (HLM 0.60)]. FS Date: 7/7/2020 1:13:53 PM

Water-Side: view of pipe, headwall, and flapgate.

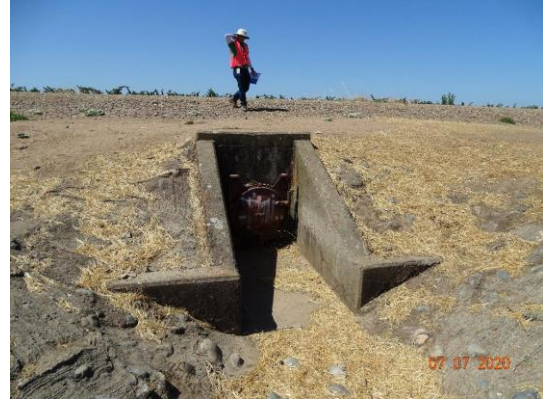
Photo 1 of 1 : UCIP_FA_2022_58906_86747.jpg

Comment Code					
Inspector Comment					
DS_ID:23935 FS_ID:58906 EP_NO: N/A Repair Type: Non-Urgent EVAL Issue: Crossing Status: Found UCIP Comments: 07/07/2020 Record updated from No Action Needed to Non Urgent. No permit has been identified authorizing pipe. This is a system feature without any modification to the system. Pipe is in good condition. Same observation as last inspection. Internal video inspection was performed in 4/24/2020. (S.Donovan - DWR UCIP) FIELD_STRUCT_DESC: 24-inch corrugated metal drainage pipe through the levee, 5 feet below the crown. Concrete U-shaped headwall on both ends. Flap gate on the waterside (WS) end. Cobble grouted spillway. Cobble grouted intake on the landside (LS). [Additional Reference(s): DWR Levee Log, 1978. USACE San Joaquin O&M Manual 612.2, 1967, (HLM 0.91)]. FS Date: 7/7/2020 1:14:37 PM

Water-Side: view of pipe, headwall, and flapgate.

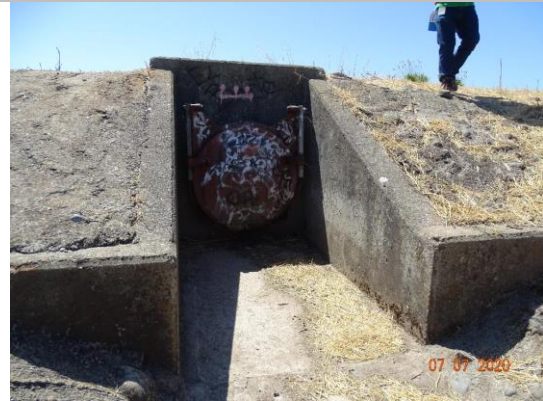
Photo 1 of 1 : UCIP_FA_2022_58908_86755.jpg

Comment Code					
Inspector Comment					
DS_ID:23937 FS_ID:58908 EP_NO: N/A Repair Type: Non-Urgent EVAL Issue: Crossing Status: Found UCIP Comments: 07/07/2020 Record updated from No Action Needed to Non URgent. No permit has been identified authorizing pipe. This is a system feature without any modification to the system. Pipe is in good condition. Same observation as last inspection. (S.Donovan - DWR UCIP) FIELD_STRUCT_DESC: 36-inch corrugated metal drainage pipe through the levee, 4 feet below the crown. Concrete U-shaped headwall on both ends. Flap gate on the waterside (WS) end. Cobble grouted spillway. Cobble grouted intake on the landside (LS). [Additional Reference(s): DWR Levee Log, 1978. USACE San Joaquin O&M Manual 612.2, 1967, (HLM 1.18)]. FS Date: 7/7/2020 1:16:27 PM

Water-Side: view of pipe with headwall and flapgate.

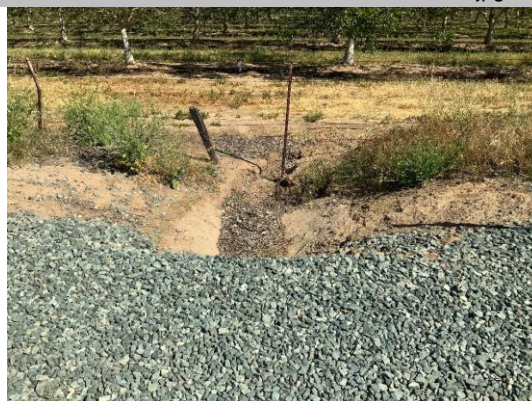
Photo 2 of 3 : UCIP_FA_2022_77603_98401.jpg

DS_ID:23940
 FS_ID:77603
 EP_NO: N/A
 Repair Type: Non-Urgent
 EVAL Issue:
 Crossing Status: Found
 UCIP Comments: 04/29/2021 Pipe status is still Non-Urgent. Unit 14 ? Middle Paddle Creek (CLM 0 to 1.38) is considered a patrol road/high ground area with no defined levee prism, any issue found between CLM 0 to 1.38 of Unit 14 will be considered a maintenance issue, or an unauthorized encroachment, or an abandoned encroachment. DWR DMP internal inspection has not found pipe integrity issues. LOF of crossing is less or equal to 4.0. Recommend inspection in 5 years. Current condition of pipe crossing does not impede access to patrol road/high ground area. No permit was found authorizing this encroachment. CVFPB will need to review crossing to determine owner. The UCIP inspection was completed with LMA representative, J. Nelson. (H. Dunn ? GEI) 06/12/2014 Debris partially blocking closure of flapgate. (W. Wylie - DWR UCIP)

LS view: Toe from crown.

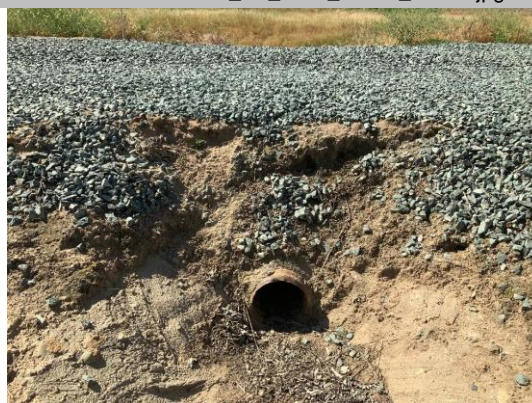
Photo 3 of 3 : UCIP_FA_2022_77603_98402.jpg

LS view: Slope and pipe inlet at toe.

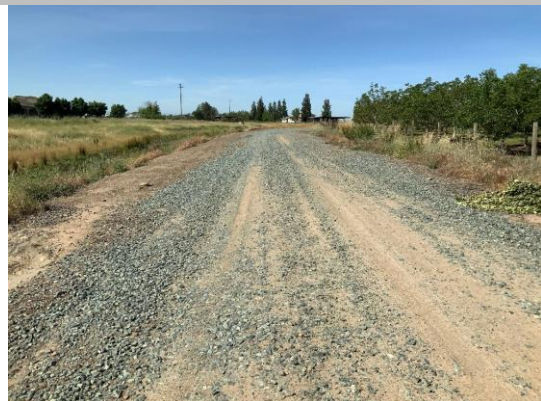
Photo 1 of 3 : UCIP_FA_2022_77605_98412.jpg

DS_ID:23942
 FS_ID:77605
 EP_NO: N/A
 Repair Type: Non-Urgent
 EVAL Issue:
 Crossing Status: Found
 UCIP Comments: 04/29/2021 Record has been upgraded from No Action Needed to Non-Urgent. Unit 14 – Middle Paddle Creek (CLM 0 to 1.38) is considered a patrol road/high ground area with no defined levee prism, any issue found between CLM 0 to 1.38 of Unit 14 will be considered a maintenance issue, or an unauthorized encroachment, or an abandoned encroachment. DWR DMP internal inspection has not found pipe integrity issues. LOF of crossing is less or equal to 4.0. Recommend inspection in 5 years. Current condition of pipe crossing does not impede access to patrol road/high ground area. No permit was found authorizing this encroachment. CVFPB will need to review crossing to determine owner. The UCIP inspection was completed with LMA representative, J. Nelson. (H. Dunn – GEI)
 FIELD_STRUCT_DESC: 12-inch corrugated metal storm drainage pipe (CMP) through the levee, 2.0 feet below the crown. Flap gate on the waterside (WS) end. Cobble grouted spillway on the WS end. Cobble grouted intake on the landside (LS). [Additional Reference(s): DWR Levee Log, 1978, (HLM 0.46). USACE San Joaquin O&M Manual 612.2, 1967, (HLM 0.46)].

Levee crown looking downstream.

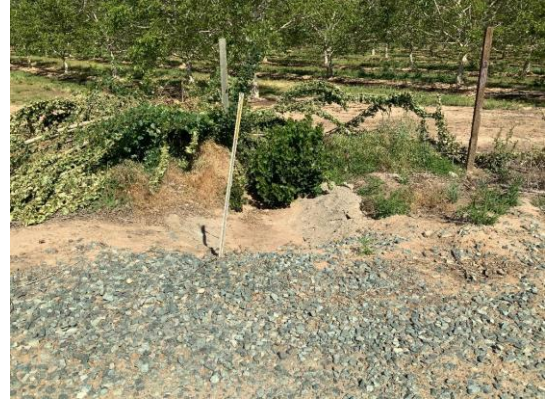
Photo 2 of 3 : UCIP_FA_2022_77605_98413.jpg

LS view: Toe from crown, marker visible.

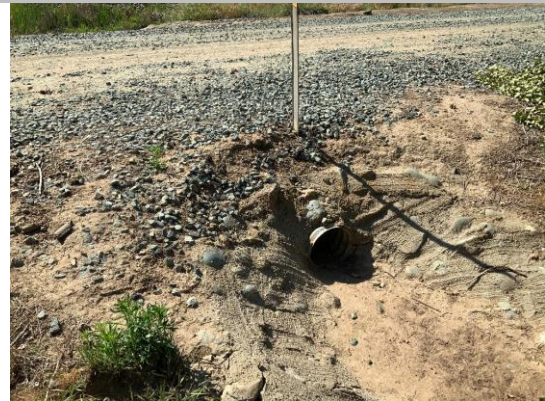
Photo 3 of 3 : UCIP_FA_2022_77605_98414.jpg

LS view: Slope and pipe inlet at toe.

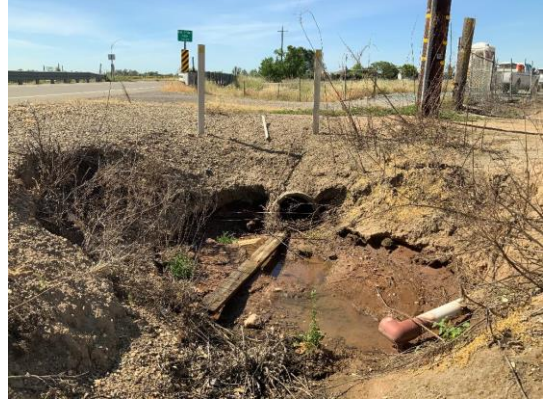
Photo 2 of 3 : UCIP_FA_2022_77606_98419.jpg

LS view: Slope and pipe inlet at toe.

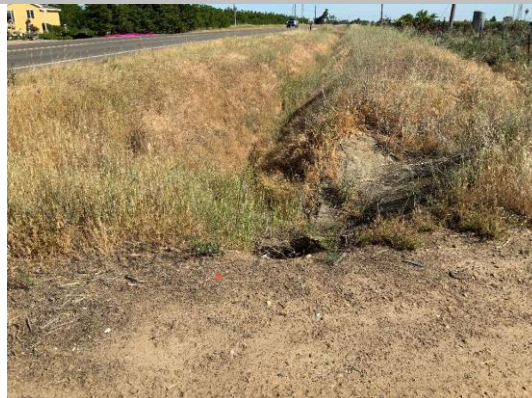
Photo 2 of 3 : UCIP_FA_2022_77609_98439.jpg

LS view: Toe from crown.

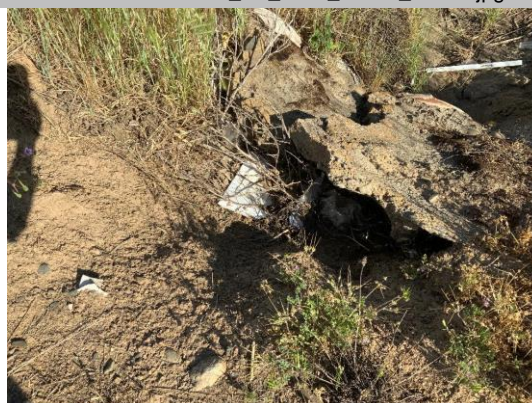
Photo 3 of 3 : UCIP_FA_2022_77609_98440.jpg

LS view: Erosion and gapping above pipe inlet on slope.

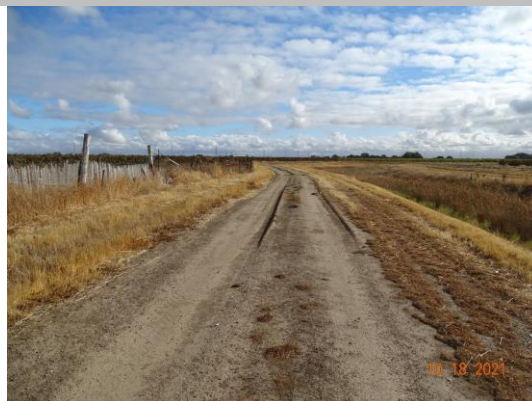
Photo 1 of 1 : FA_2022_NA0017_158_22_20220919_00002.jpg

LM Start	0.60	Rating **	M	Issue No.	22
LM End	0.60	Issue Type +	Ma	Location *	CR
Category	Earthen Levee			GPS Latitude/Longitude	
				Start	End
Item	Crown Surface / Depressions / Rutting			38.111733 °	38.111733 °
				-121.150229 °	-121.150229 °
DWR ID	DWR_NA0017_14_f_2020_22				
Comment Code					
C2 : Repair depressions or ruts in the crown or slope.					
Inspector Comment

View of tire ruts on the surface road. Fall 2021

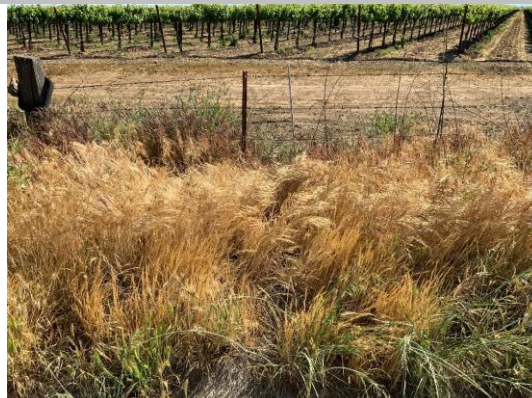
Photo 2 of 3 : UCIP_FA_2022_77610_98443.jpg

LS view: Toe from crown.

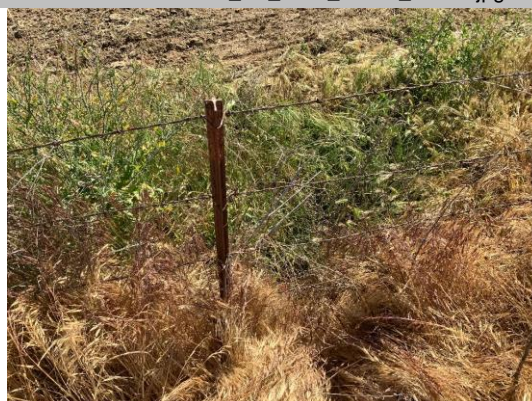
Photo 3 of 3 : UCIP_FA_2022_77610_98444.jpg

LS view: Pipe inlet covered by vegetation and barbed wire at toe.

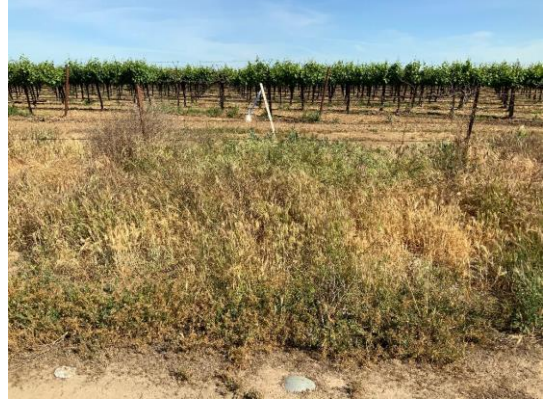
Photo 2 of 3 : UCIP_FA_2022_77611_98448.jpg

LS view: Toe from crown, marker visible.

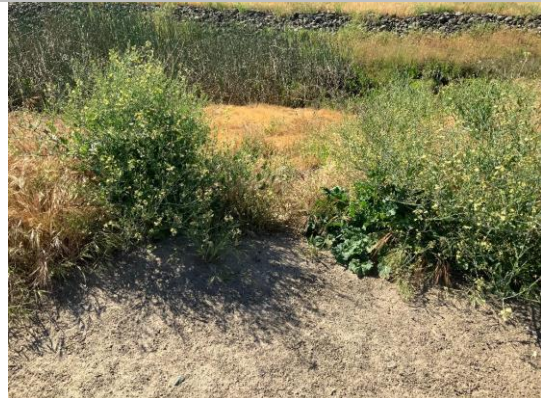
Photo 2 of 3 : UCIP_FA_2022_77612_98455.jpg

WS view: Toe from crown.

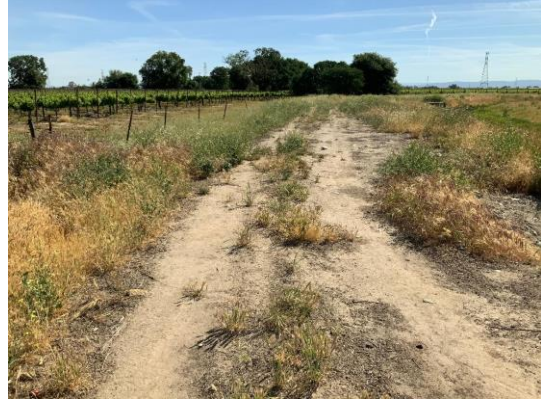
Photo 1 of 3 : UCIP_FA_2022_77614_98468.jpg

Comment Code						
Inspector Comment						
DS_ID:23949 FS_ID:77614 EP_NO: N/A Repair Type: Non-Urgent EVAL Issue: 11, Maintenance Compliance Issue Crossing Status: Found UCIP Comments: 04/29/2021 Pipe status is still Non-Urgent. Unit 14 – Middle Paddle Creek (CLM 0 to 1.38) is considered a patrol road/high ground area with no defined levee prism, any issue found between CLM 0 to 1.38 of Unit 14 will be considered a maintenance issue, or an unauthorized encroachment, or an abandoned encroachment. DWR DMP internal inspection has not found pipe integrity issues. LOF of crossing is less or equal to 4.0. Recommend inspection in 5 years. Current condition of pipe crossing does not impede access to patrol road/high ground area. LS and WS pipe inlet and flapgate covered with vegetation, recommend removal. No permit was found authorizing this encroachment. CVFPB will need to review crossing to determine owner. The UCIP inspection was completed with LMA representative, J. Nelson. (H. Dunn – GEI) 06/12/2014 Pipe appears abandoned. Levee appears Abandoned. (W. Wylie - DWR UCIP) FIELD_STRUCT_DESC: *ABANDONED* 12-inch corrugated metal storm drainage pipe (CMP) through the levee, 2.5 feet below the crown. Flap gate on the waterside (WS) end. Cobble grouted spillway on the WS end. Cobble grouted intake on the landside (LS). [Additional Reference(s): DWR Levee Log, 1978, (HLM 1.12). USACE San Joaquin O&M Manual 612.2, 1967, (HLM 1.12)]. FS Date: 4/29/2021

Levee crown looking upstream.

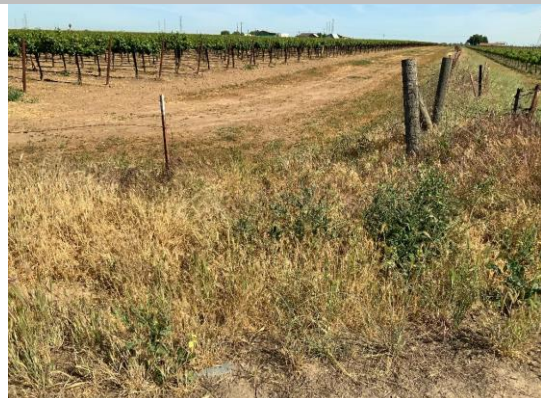
Photo 2 of 3 : UCIP_FA_2022_77614_98469.jpg

LS view: Toe from crown.

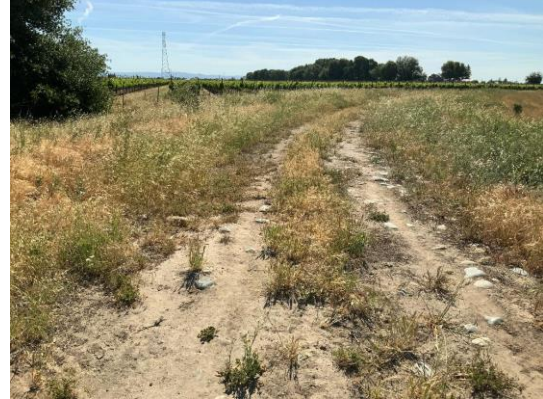
Photo 1 of 3 : UCIP_FA_2022_77615_98476.jpg

Comment Code					
Inspector Comment					
DS_ID:23950 FS_ID:77615 EP_NO: N/A Repair Type: Non-Urgent EVAL Issue: 11, Maintenance Compliance Issue Crossing Status: Found UCIP Comments: 04/29/2021 Pipe status is still Non-Urgent. Unit 14 – Middle Paddle Creek (CLM 0 to 1.38) is considered a patrol road/high ground area with no defined levee prism, any issue found between CLM 0 to 1.38 of Unit 14 will be considered a maintenance issue, or an unauthorized encroachment, or an abandoned encroachment. DWR DMP internal inspection has not found pipe integrity issues. LOF of crossing is less or equal to 4.0. Recommend inspection in 5 years. Current condition of pipe crossing does not impede access to patrol road/high ground area. Pipe is open on both ends, no flapgate. No permit was found authorizing this encroachment. CVFPB will need to review crossing to determine owner. The UCIP inspection was completed with LMA representative, J. Nelson. (H. Dunn – GEI) 06/12/2014 Pipe open on both ends. Levee appears abandoned. (W. Wylie - DWR UCIP) FIELD_STRUCT_DESC: 48-inch reinforced concrete storm drainage pipe (RCP) through the levee, 5.5 feet below the crown. Pipe open on both ends. Cobble grouted spillway on the waterside (WS) end. Cobble grouted intake on the landside (LS). [Additional Reference(s): DWR Levee Log, 1978, (HLM 1.17). USACE San Joaquin O&M Manual 612.2, 1967, (HLM 1.17)]. FS Date: 4/29/2021

Levee crown looking upstream.

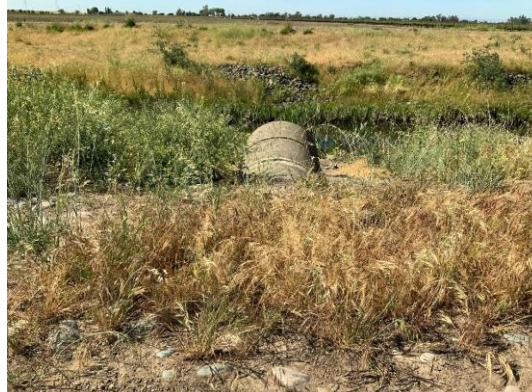
Photo 2 of 3 : UCIP_FA_2022_77615_98477.jpg

WS view: Pipe visible at toe from crown.

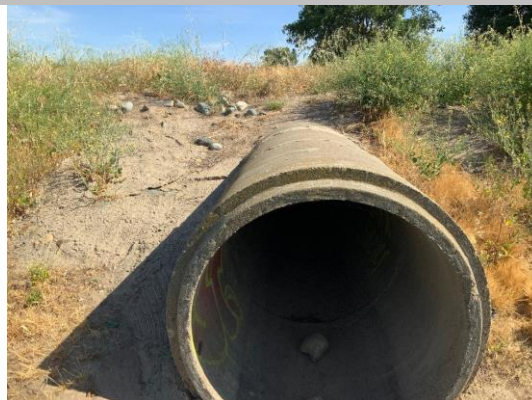
Photo 3 of 3 : UCIP_FA_2022_77615_98478.jpg

WS view: Slope and pipe outlet at toe.

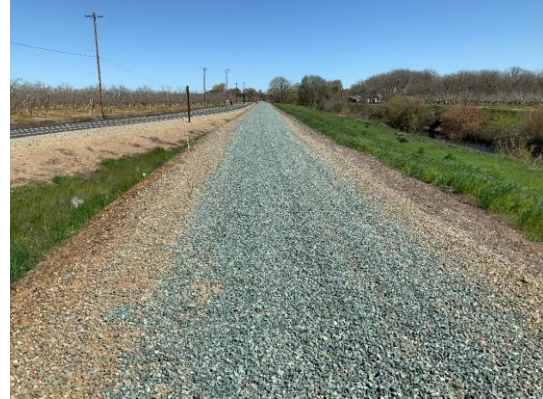
Photo 1 of 3 : UCIP_FA_2022_66898_93981.jpg

Comment Code						
Inspector Comment						
DS_ID:23199 FS_ID:66898 EP_NO: N/A Repair Type: Non-Urgent EVAL Issue: 11, Maintenance Compliance Issue Crossing Status: Found UCIP Comments: 03/26/2021 Record has been upgraded from No Action Needed to Non-Urgent. Unit 15 – Mormon Slough (CLM 0 to 1.50 and 5.0 - 11.0) are considered a patrol road/high ground area with no defined levee prism, any issue found between CLM 0 - 1.50 and 5.0 – 11.0 of Unit 15 will be considered a maintenance issue, or an unauthorized encroachment, or an abandoned encroachment. DWR DMP internal video inspection has found pipe integrity issues. LOF of crossing is between 5 and 6. Crossing will be monitored until funding becomes available to address the issues. Current condition of pipe crossing does not impede access to patrol road/high ground area. No permit was found authorizing this encroachment. CVFPB will need to review crossing to determine owner. The UCIP inspection was completed with LMA representative, H. Latu. (H. Dunn – GEI) 04/09/2014 Deformed inlet opening. Needs cleaning and clearing on inlet opening on landside. (P. Tariq - DWR UCIP) FIELD_STRUCT_DESC: *High Ground* 18-inch corrugated metal drainage pipe through the levee, 4.5 feet below the crown. Grouted spillway on the waterside (WS) end. Open on both ends. [Additional Reference(s): DWR Levee Log, 1992. USACE San Joaquin O&M Manual 611.1, Volume F, (HLM 1.18)]. FS Date: 3/26/2021

Levee crown looking upstream.

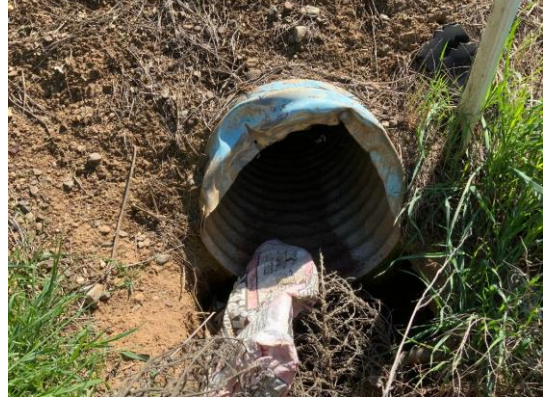
Photo 2 of 3 : UCIP_FA_2022_66898_93985.jpg

LS view: Inside pipe inlet.

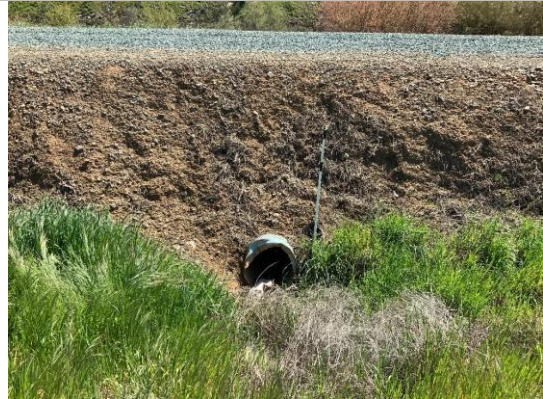
Photo 3 of 3 : UCIP_FA_2022_66898_93984.jpg

LS view: Pipe end at toe.

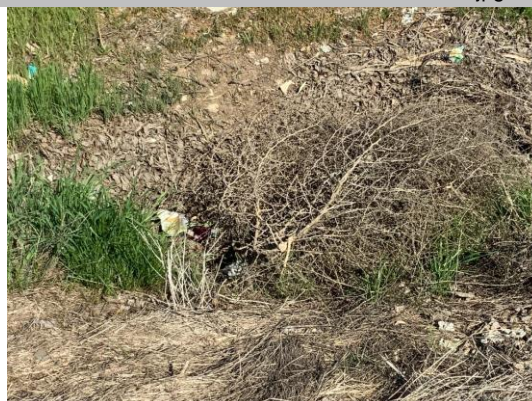
Photo 2 of 3 : UCIP_FA_2022_66899_94001.jpg

LS view: Pipe end covered in vegetation and dirt.

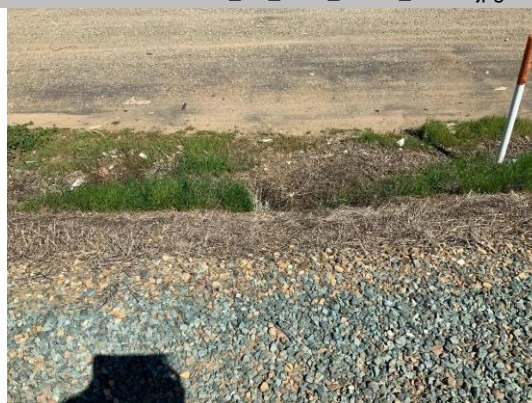
Photo 3 of 3 : UCIP_FA_2022_66899_94000.jpg

LS view: Toe from crown.

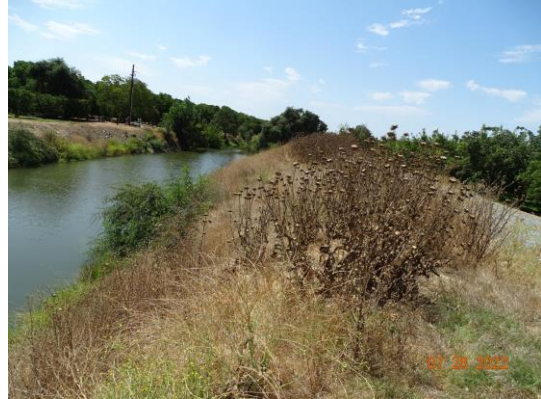
Photo 1 of 1 : SJR2022_NA0017U15RM18.45_2.JPG

LM Start	4.51	Rating **	M	Issue No.	14
LM End	4.52	Issue Type +	Ma	Location *	
Category	Supplemental			GPS Latitude/Longitude	
				Start	End
Item	DWR Erosion Survey			38.009753 °	38.009753 °
				-121.069559 °	-121.069559 °
DWR ID	NA0017U15RM18.45				
Comment Code					
Inspector Comment					
Site ID: NA0017U15RM18.45					
07/28/2022: From 2021 to present, no significant changes were observed during the annual survey.					
07/23/2020: This site was discovered during the DWR Fall 2015 Levee Inspections. Although dense vegetation is limiting the view, the erosion, which extends to the upper levee slope, could still be seen.

7/28/2022: View of the erosion looking downstream. Dense vegetation is limiting visibility.

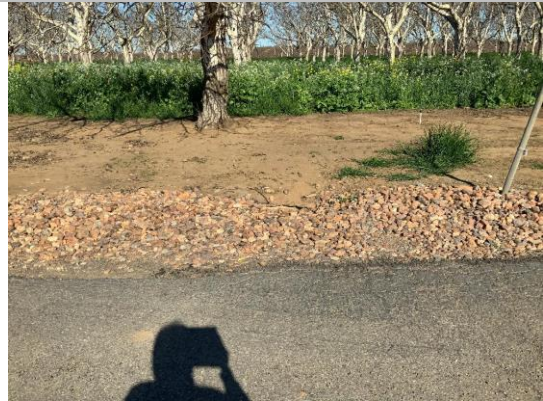
Photo 2 of 3 : UCIP_FA_2022_66920_94207.jpg

LS view: Toe from crown.

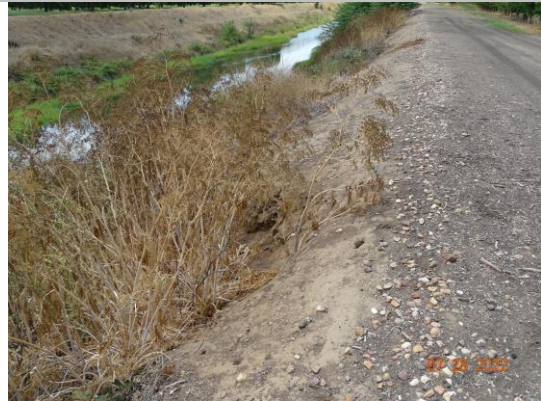
Photo 1 of 2 : SJR2022_NA0017U15RM17.67_2.JPG

*This area is patrol road only and therefore the site is not rated
07/28/2022: No significant changes were observed since the previous inspection.

06/29/2021: There is more vegetation on the slope. Otherwise, no significant changes were observed since the previous inspection.
07/24/2020: Some burrowing activity observed. Site is likely to extend toward downstream during the next rain event.

08/28/2019: The erosion is located at the upper slope of the channel bank and was likely caused by rainfall runoff.

7/28/2022: View of the erosion looking downstream.

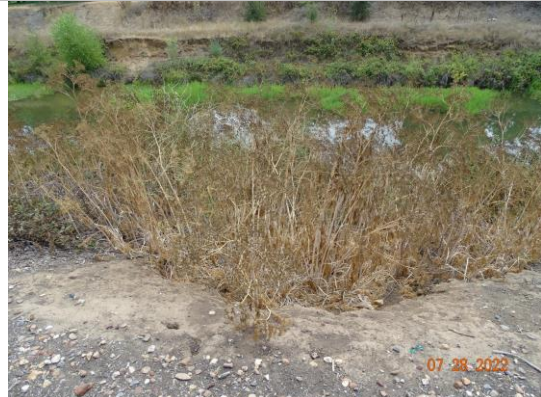
Photo 2 of 2 : SJR2022_NA0017U15RM17.67_3.JPG

7/28/2022: Another view of the erosion.
