**Flood Control Project Maintenance
Levee Inspections**

Maintenance Issue Types Only, Levee Inspection Report By Mile - Fall 2022

San Joaquin County Flood Control and Water Conservation District

Waterway	Bank	Unit Miles	Inspection Start/End	Inspector
Unit No. 01 Littlejohn Creek	Left	2.59	10/13/2022 10/13/2022	Alberto De Leon

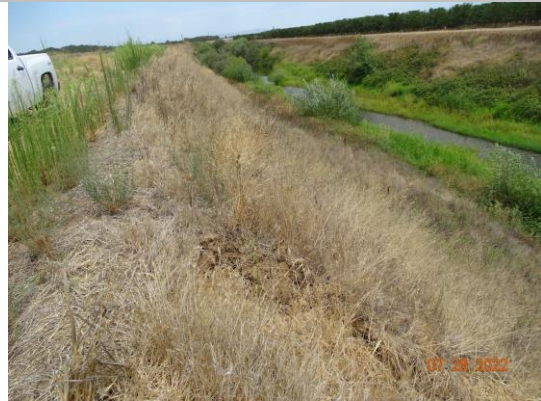
Photo 1 of 1 : SJR2022_NA0017U15RM15.25_2.JPG

LM Start	7.67	Rating **	A/W	Issue No.	17
LM End	7.68	Issue Type +	Ma	Location *	
Category	Supplemental			GPS Latitude/Longitude	
				Start	End
Item	DWR Erosion Survey			37.976275 °	37.976275 °
				-121.106364 °	-121.106364 °
DWR ID	NA0017U15RM15.25				
Comment Code					
Inspector Comment					
Site ID: NA0017U15RM15.25					
*This area is patrol road only and therefore the site is not rated					
07/28/2022: No changes were observed since the previous inspection.					
The erosion is visible in two locations.					
07/24/2020: This site was discovered during the DWR Fall 2017 Levee					
Inspections. The erosion is caused by surface runoff and likely to cut					
into the patrol road during the next storm events.

7/28/2022: View of the erosion on the upper slope looking upstream.

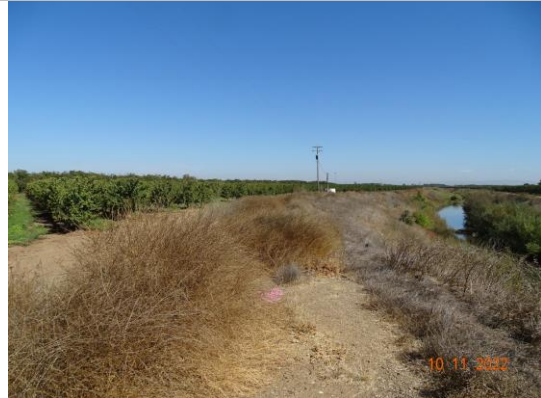
Photo 1 of 1 : FA_2022_NA0017_159_250_20221025_00510.jpg

View of wild vegetation growing over the surface road. Fall 2022

LM Start	8.11	Rating **	M	Issue No.	250
LM End	8.17	Issue Type +	Ma	Location *	CR
Category	Earthen Levee			GPS Latitude/Longitude	
				Start	End
Item	Vegetation			37.972583 °	37.971867 °
				-121.112968 °	-121.113698 °
DWR ID	DWR_NA0017_15_f_2022_250				
Comment Code					
V3 : Keep the crown roadway free of vegetation.					
Inspector Comment

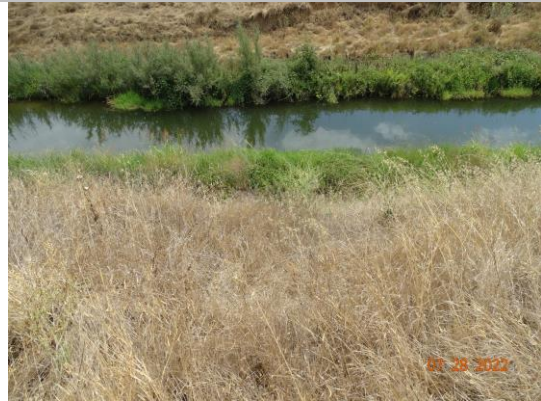
Photo 1 of 1 : SJR2022_NA0017U15RM14.49_2.JPG

LM Start	8.43	Rating **	A/W	Issue No.	6	
LM End	8.44	Issue Type +	Ma	Location *		
Category	Supplemental			GPS Latitude/Longitude		
				Start	End	
Item	DWR Erosion Survey			37.969711 °	37.969711 °	
				-121.116739 °	-121.116739 °	
DWR ID	NA0017U15RM14.49					
Comment Code						
Inspector Comment						
Site ID: NA0017U15RM14.49						
*This area is patrol road only and therefore the site is not rated						
07/28/2022: From 2014 to present, no significant changes were						
observed during the annual survey. There are signs of animal activity.						
09/12/2013: The erosion has been caused by runoff.

7/28/2022: View of the eroded levee slope.

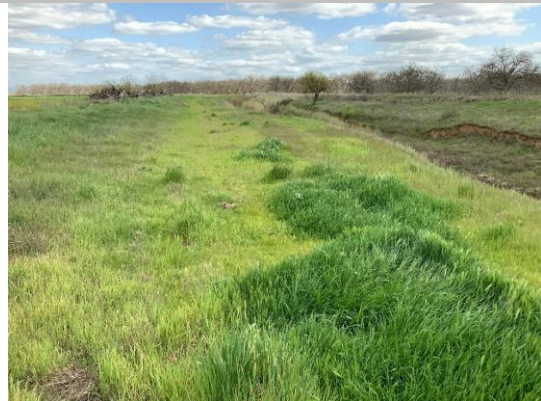
Photo 1 of 3 : UCIP_FA_2022_65489_94355.jpg

Comment Code						
Inspector Comment						
DS_ID:23227						
FS_ID:65489						
EP_NO: N/A						
Repair Type: Non-Urgent						
EVAL Issue: 11, Maintenance Compliance Issue						
Crossing Status: Found						
UCIP Comments: 03/25/2021 Pipe status is still Non-Urgent. Unit 15 – Mormon Slough (CLM 0 to 1.50 and 5.0 - 11.0) are considered a patrol road/high ground area with no defined levee prism, any issue found between CLM 0 - 1.50 and 5.0 – 11.0 of Unit 15 will be considered a maintenance issue, or an unauthorized encroachment, or an abandoned encroachment. LS pipe end covered in dirt and veegestation, recommend cleaning out. Cannot see WS pipe end. Current condition of pipe crossing does not impede access to patrol road/high ground area. No permit was found authorizing this encroachment. CVFPB will need to review crossing to determine owner. The UCIP inspection was completed with LMA representative, H. Latu. (H. Dunn – GEI)

04/10/2014 Distorted inlet pipe opening on landside. No pipe found on waterside. Dense vegetation and steep slope on waterside. (P. Tariq - DWR UCIP)						
FIELD_STRUCT_DESC: 18-inch CM pipe through the levee, 1.0 feet below the crown. O&M Manual SJR Assumed 999.						
FS Date: 3/25/2021

Levee crown looking upstream.

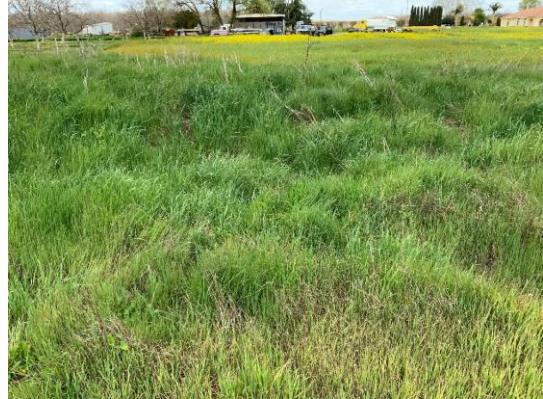
Photo 2 of 3 : UCIP_FA_2022_65489_94356.jpg

LS view: Toe from crown, pipe not visible.

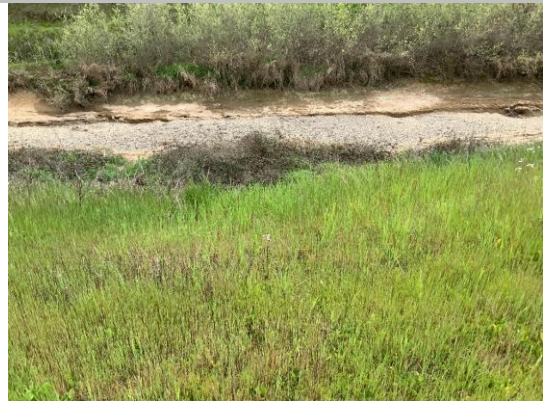
Photo 3 of 3 : UCIP_FA_2022_65489_94358.jpg

WS view: Toe from crown, no pipe visible.

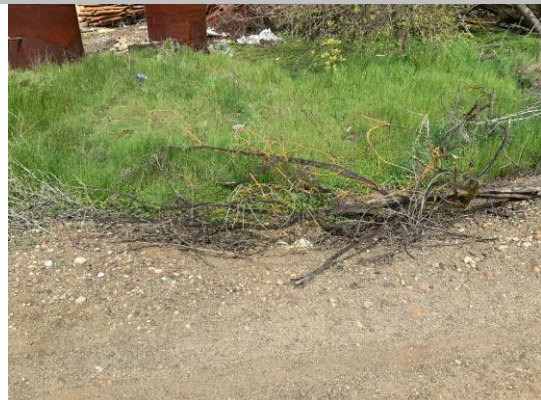
Photo 2 of 3 : UCIP_FA_2022_66938_94364.jpg

LS view: Toe from crown.

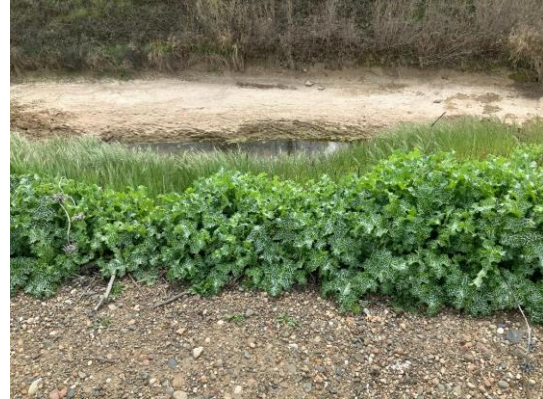
Photo 3 of 3 : UCIP_FA_2022_66938_94367.jpg

WS view: Toe from crown, no pipe visible.

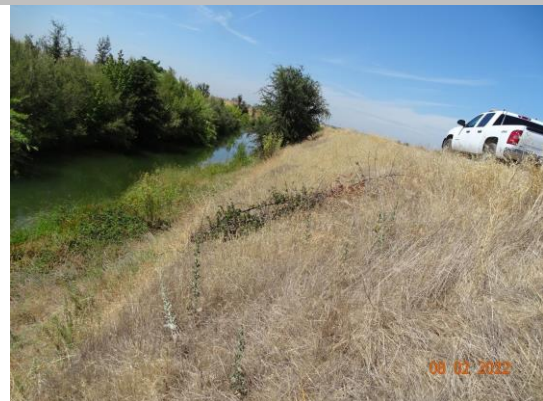
Photo 1 of 2 : SJR2022_NA0017U15RM13.87_3.JPG

LM Start	8.81	Rating **	A/W	Issue No.	7
LM End	8.83	Issue Type +	Ma	Location *	
Category	Supplemental			GPS Latitude/Longitude	
				Start	End
Item	DWR Erosion Survey			37.968060 °	37.968060 °
				-121.123299 °	-121.123299 °
DWR ID	NA0017U15RM13.87				
Comment Code					
Inspector Comment					
Site ID: NA0017U15RM13.87					
*This area is patrol road only and therefore the site is not rated					
08/02/2022: From 2015 to present, no significant changes were					
observed during the annual survey.					
08/20/2014: Both ends of the erosion site are protected by riprap.

8/2/2022: View of the erosion looking downstream.

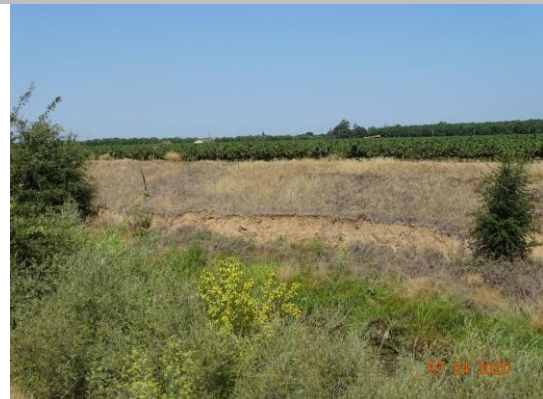
Photo 2 of 2 : SJR2022_NA0017U15RM13.87_02.JPG

7/24/2020: View of the erosion from the opposite bank.

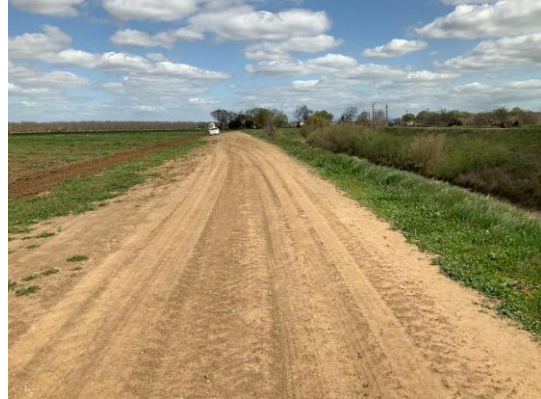
Photo 1 of 3 : UCIP_FA_2022_65486_94378.jpg

Comment Code					
Inspector Comment					
DS_ID:23230 FS_ID:65486 EP_NO: N/A Repair Type: Non-Urgent EVAL Issue: Crossing Status: Not Found UCIP Comments: 03/25/2021 Record has been upgraded from No Action Needed to Non-Urgent. Unit 15 – Mormon Slough (CLM 0 to 1.50 and 5.0 - 11.0) are considered a patrol road/high ground area with no defined levee prism, any issue found between CLM 0 - 1.50 and 5.0 – 11.0 of Unit 15 will be considered a maintenance issue, or an unauthorized encroachment, or an abandoned encroachment. Pipe not found by visual inspection. Current condition of pipe crossing does not impede access to patrol road/high ground area. No permit was found authorizing this encroachment. CVFPB will need to review crossing to determine owner. The UCIP inspection was completed with LMA representative, H. Latu. (H. Dunn – GEI) FIELD_STRUCT_DESC: 18-inch corrugated metal drainage pipe through the levee, 3 feet below the crown. Grouted inlet and outlet. [Additional Reference(s): DWR Levee Log, 1992. USACE San Joaquin O&M Manual 611.1, Volume F, (HLM 9.12)]. FS Date: 3/25/2021

Levee crown looking upstream.

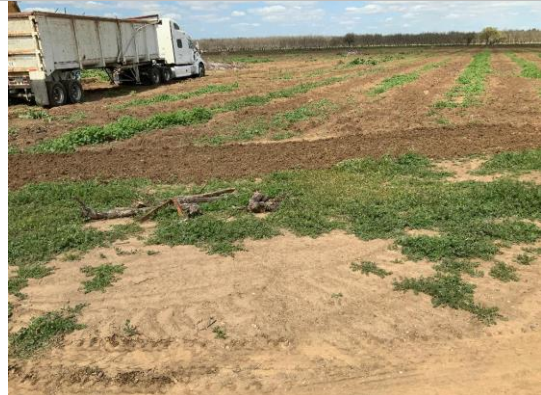
Photo 2 of 3 : UCIP_FA_2022_65486_94379.jpg

LS view: Toe from crown, no pipe visible.

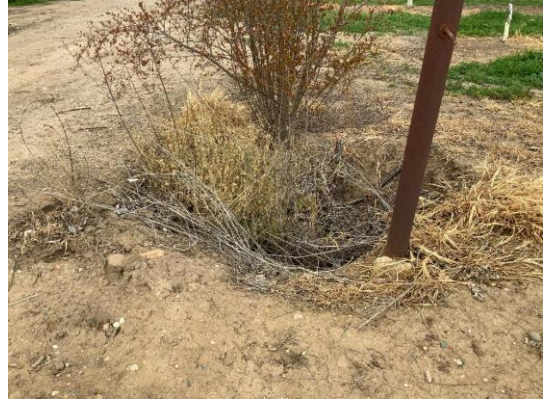
Photo 2 of 3 : UCIP_FA_2022_66952_94408.jpg

LS view: Toe from crown.

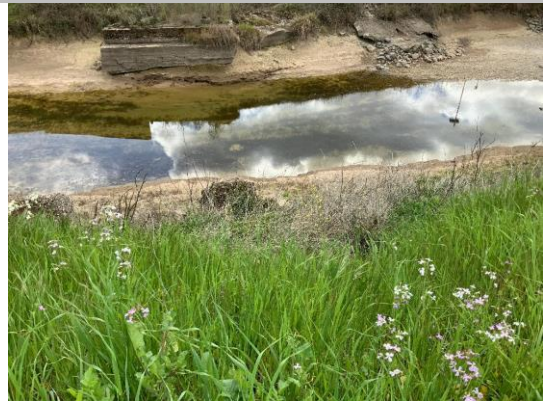
Photo 3 of 3 : UCIP_FA_2022_66952_94410.jpg

WS view: Toe from crown.

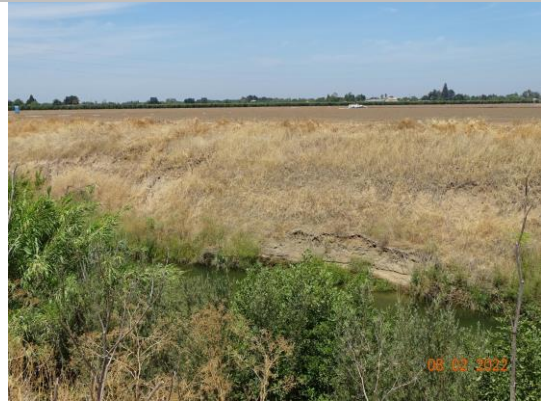
Photo 1 of 2 : SJR2022_NA0017U15RM13.22_2.JPG

*This area is patrol road only and therefore the site is not rated
08/02/2022: No significant changes were observed since the previous inspection. The length was extended to 350 ft based on more accurate field measurements.

07/24/2020: The site was discovered during the field survey. The erosion is immediately downstream of a newly repaired erosion site (NA0017U15RM13.25). The erosion begins at the shoulder and extends down the entire slope. Some sloughing is visible on the upper slope and the stream has cut into the bank.

8/2/2022: View of the erosion from the opposite bank.

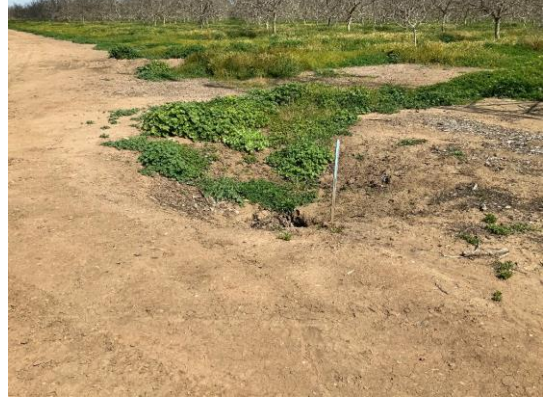
Photo 2 of 3 : UCIP_FA_2022_66955_94428.jpg

LS view: Toe from crown.

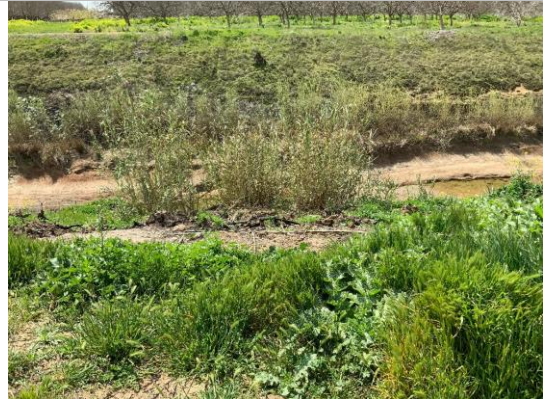
Photo 3 of 3 : UCIP_FA_2022_66955_94431.jpg

WS view: Toe from crown.

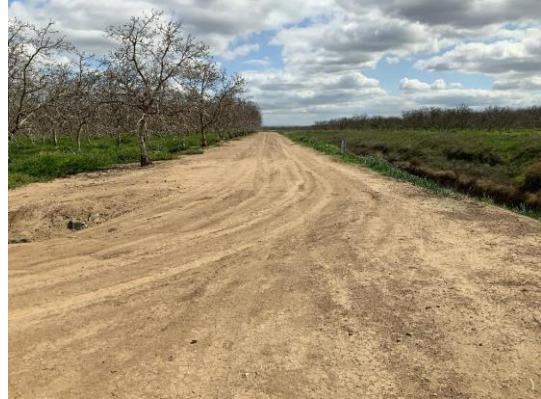
Photo 1 of 3 : UCIP_FA_2022_66956_94436.jpg

Comment Code						
Inspector Comment						
DS_ID:23236 FS_ID:66956 EP_NO: N/A Repair Type: Non-Urgent EVAL Issue: 11, Maintenance Compliance Issue Crossing Status: Found UCIP Comments: 03/25/2021 Pipe status is still Non-Urgent. Unit 15 - Mormon Slough (CLM 0 to 1.50 and 5.0 - 11.0) are considered a patrol road/high ground area with no defined levee prism, any issue found between CLM 0 - 1.50 and 5.0 - 11.0 of Unit 15 will be considered a maintenance issue, or an unauthorized encroachment, or an abandoned encroachment. LS pipe end filled with debris and dirt, recommend cleaning out. WS pipe end not seen. DWR DMP internal video inspection has not found pipe integrity issues. LOF of crossing is less or equal to 4.0. Recommend next video inspection in 5 years. Current condition of pipe crossing does not impede access to patrol road/high ground area. No permit was found authorizing this encroachment. CVFPB will need to review crossing to determine owner. The UCIP inspection was completed with LMA representative, H. Latu. (H. Dunn - GEI) 04/10/2014 May need cleaning of the pipe. (P. Tariq - DWR UCIP)Pipe not visible on waterside. FIELD_STRUCT_DESC: 18-inch corrugated metal drainage pipe through the levee, 4.5 feet below the crown. Grouted inlet and outlet. [Additional Reference(s): DWR Levee Log, 1992. USACE San Joaquin O&M Manual 611.1, Volume F, (HLM 10.22)]. FS Date: 3/25/2021

Levee crown looking upstream.

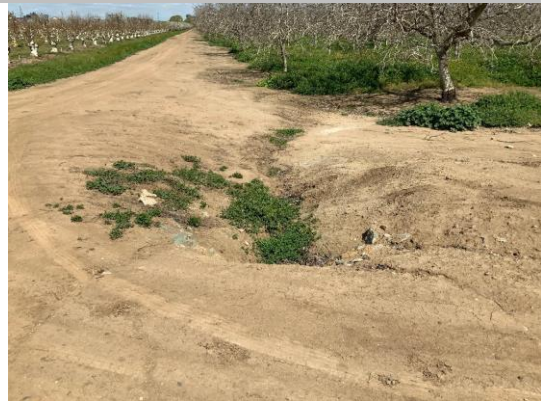
Photo 2 of 3 : UCIP_FA_2022_66956_94437.jpg

LS view: Toe from crown.

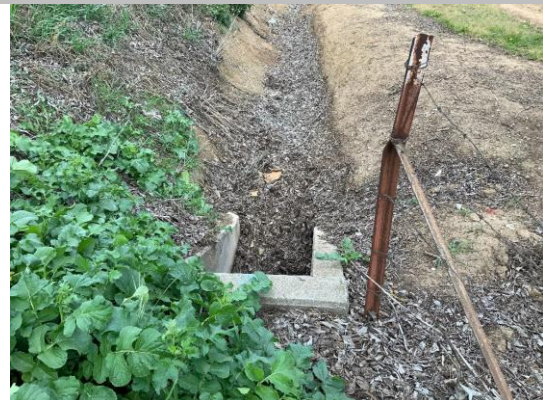
Photo 2 of 3 : UCIP_FA_2022_66959_94456.jpg

LS view: Toe from crown, headwall visible.

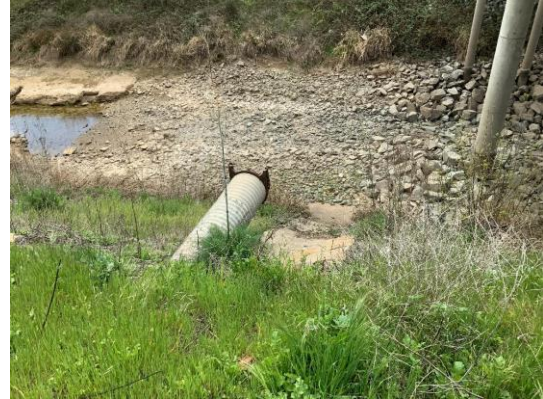
Photo 3 of 3 : UCIP_FA_2022_66959_94454.jpg

WS view: Toe from crown, pipe and flapgate visible.

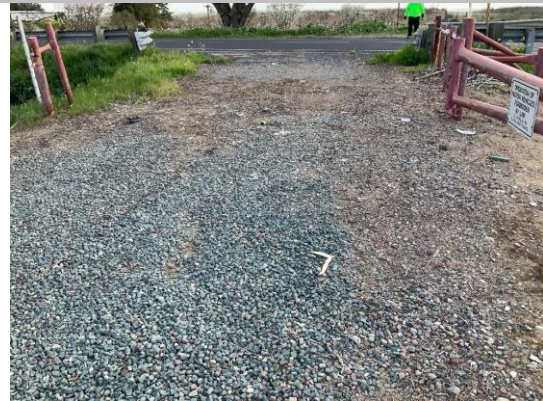
Photo 1 of 3 : UCIP_FA_2022_65502_94465.jpg

DS_ID:23238
FS_ID:65502
EP_NO: N/A
Repair Type: Non-Urgent
EVAL Issue: 11, Maintenance Compliance Issue
Crossing Status: Found
UCIP Comments: 03/25/2021 Pipe status is still Non-Urgent. Unit 15 – Mormon Slough (CLM 0 to 1.50 and 5.0 - 11.0) are considered a patrol road/high ground area with no defined levee prism, any issue found between CLM 0 - 1.50 and 5.0 – 11.0 of Unit 15 will be considered a maintenance issue, or an unauthorized encroachment, or an abandoned encroachment. Cannot see inlet or pipe on LS, likely covered in trash or vegetation, recommend clearing out. DWR DMP internal video inspection has not found pipe integrity issues. LOF of crossing is less or equal to 4.0. Recommend next video inspection in 5 years. Current condition of pipe crossing does not impede access to patrol road/high ground area. No permit was found authorizing this encroachment. CVFPB will need to review crossing to determine owner. The UCIP inspection was completed with LMA representative, H. Latu. (H. Dunn – GEI) 04/10/2014 Pipe buried on landside. May need cleaning of vegetation debris in inlet opening. (P. Tariq - DWR UCIP)

FIELD_STRUCT_DESC: 18-inch corrugated metal drainage pipe through the levee, 7.5 feet below the crown. Flap gate on the waterside (WS). [Additional Reference(s): DWR Levee Log, 1992. USACE San Joaquin O&M Manual 611.1, Volume F, (HLM 10.49)].
FS Date: 3/25/2021

Levee crown looking upstream.

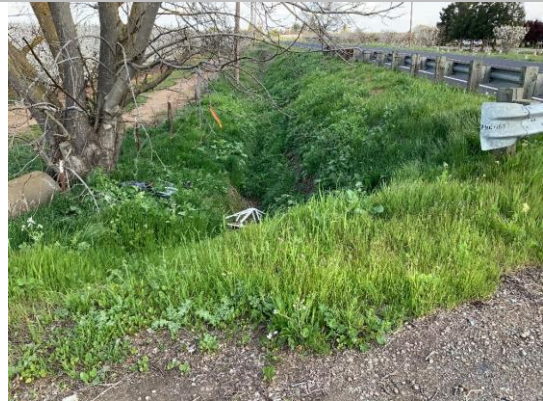
Photo 2 of 3 : UCIP_FA_2022_65502_94466.jpg

LS view: Toe from levee crown.

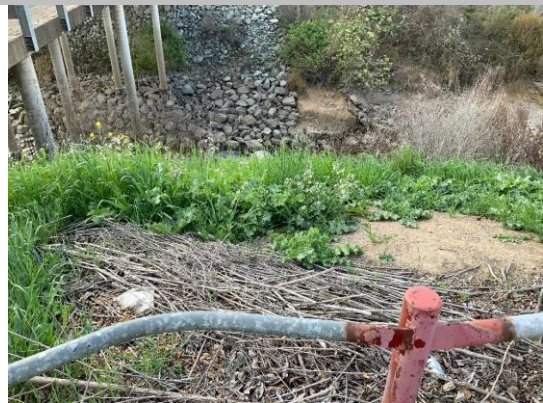
Photo 3 of 3 : UCIP_FA_2022_65502_94468.jpg

WS view: Toe from crown.

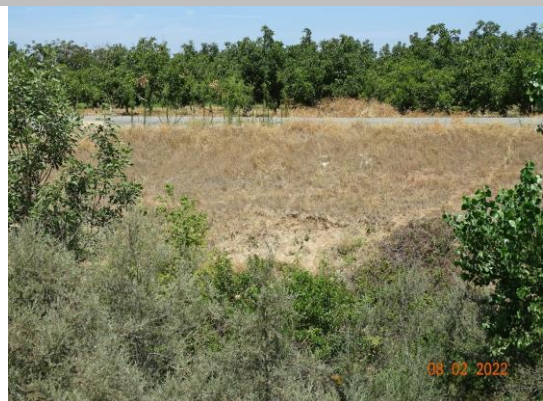
Photo 1 of 1 : SJR2022_NA0017U15RM12.12_2.JPG

*This area is patrol road only and therefore the site is not rated
08/02/2022: From 2020 to present, no significant changes were observed during the annual survey.

08/28/2019: The erosion is located at the lower slope of the channel bank and covered by dense vegetation.

8/2/2022: View of the erosion from the opposite bank.

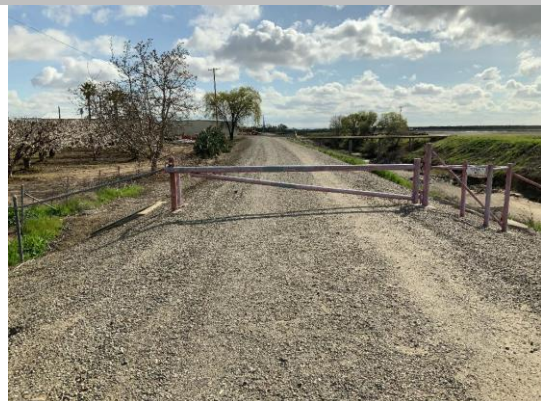
Photo 1 of 3 : UCIP_FA_2022_67088_94524.jpg

Comment Code					
Inspector Comment					
DS_ID:23243 FS_ID:67088 EP_NO: N/A Repair Type: Urgent EVAL Issue: 1, Pipe Integrity Crossing Status: Found UCIP Comments: 03/25/2021 The record has been upgraded from Non-Urgent to Urgent. Pipe is heavily grouted around on WS, fairly hidden. No flapgate, open on both ends. DWR DMP internal video inspection has found pipe integrity issues. LOF of crossing is between 5 and 6. Crossing will be monitored until funding becomes available to address the issues. No permit was found authorizing this encroachment. CVFPB will need to review crossing to determine owner. The UCIP inspection was completed with LMA representative, H. Latu. (H. Dunn – GEI) 04/14/2014 Distorted outlet pipe on waterside. (P. Andy - DWR UCIP) FIELD_STRUCT_DESC: 18-inch corrugated metal drainage pipe, 4 feet below the roadway. Grouted outlet on the waterside (WS). [Additional Reference(s): DWR Levee Log, 1992. USACE San Joaquin O&M Manual 611.1, Volume F, (HLM 11.64)]. FS Date: 3/25/2021

Levee crown looking upstream.

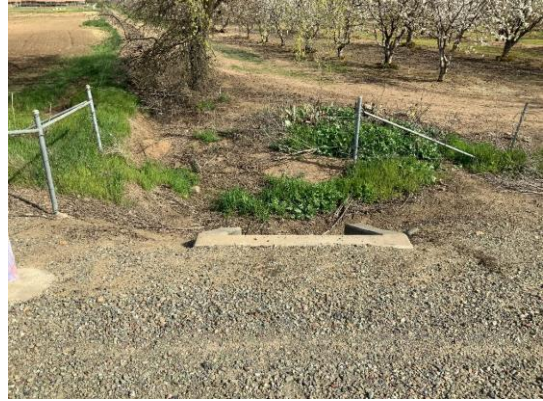
Photo 2 of 3 : UCIP_FA_2022_67088_94525.jpg

LS view: Toe from crown, headwall visible.

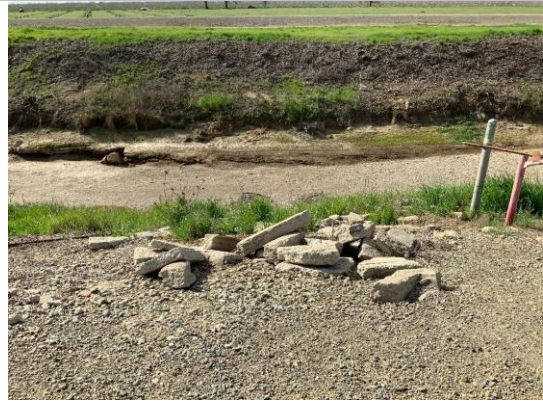
Photo 3 of 3 : UCIP_FA_2022_67088_94528.jpg

WS view: Toe from crown.

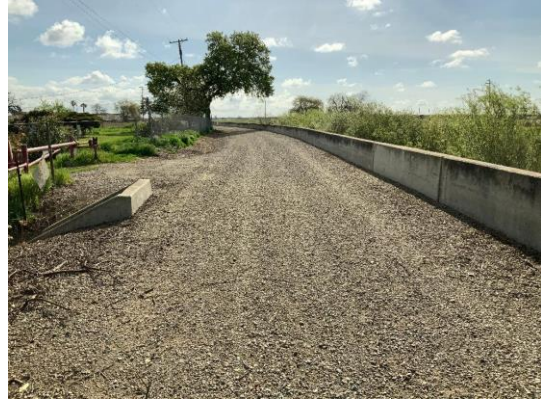
Photo 1 of 3 : UCIP_FA_2022_67087_94534.jpg

Comment Code						
Inspector Comment						
DS_ID:23244 FS_ID:67087 EP_NO: N/A Repair Type: Non-Urgent EVAL Issue: Crossing Status: Found UCIP Comments: 03/25/2021 The record has been upgraded from No Action Needed to Non-Urgent. DWR DMP internal video inspection has not found pipe integrity issues. LOF of crossing is less or equal to 4.0. Recommend next video inspection in 5 years. No permit was found authorizing this encroachment. CVFPB will need to review crossing to determine owner. The UCIP inspection was completed with LMA representative, H. Latu. (H. Dunn – GEI) 04/14/2014 New pipe and flapgate. (P. Andy - DWR UCIP) FIELD_STRUCT_DESC: 30-inch corrugated metal drainage pipe through the levee, 4.5 feet below the crown. Flap gate on the waterside (WS). Headwall with open inlet pipe on the landside (LS). Grouted outlet. [Additional Reference(s): DWR Levee Log, 1992, 18-inch pipe listed. USACE San Joaquin O&M Manual 611.1, Volume F, (HLM 11.79) 18-inch pipe listed]. FS Date: 3/25/2021

Levee crown looking upstream.

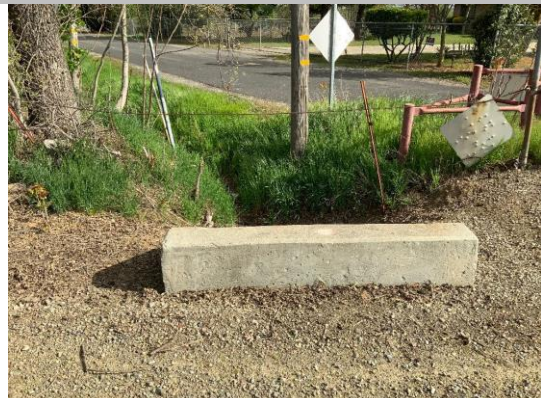
Photo 2 of 3 : UCIP_FA_2022_67087_94535.jpg

LS view: Toe from crown, headwall visible.

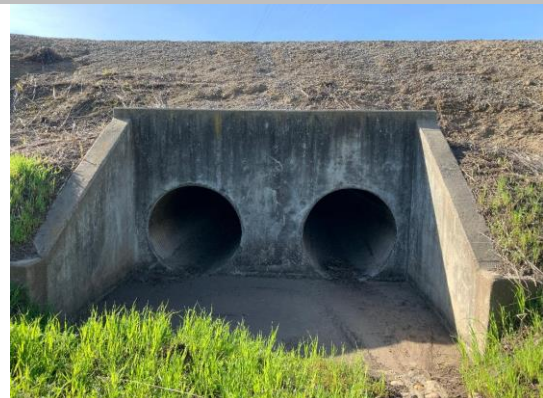
Photo 2 of 3 : UCIP_FA_2022_67086_94578.jpg

LS view: Headwall at toe.

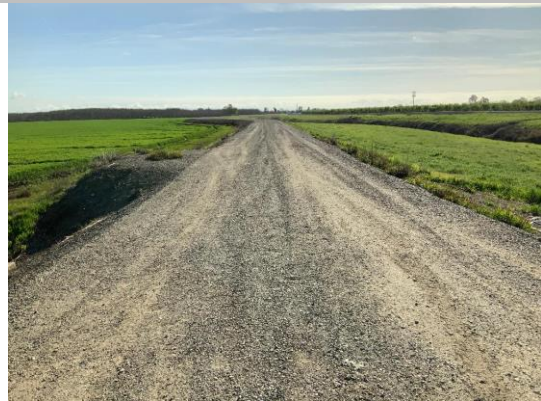
Photo 1 of 3 : UCIP_FA_2022_67085_94588.jpg

DS_ID:23454
 FS_ID:67085
 EP_NO: N/A
 Repair Type: Urgent
 EVAL Issue: 1, Pipe Integrity
 Crossing Status: Found
 UCIP Comments: 03/25/2021 The record has been upgraded from No Action Needed to Urgent. Significant peeling of metal inside LS pipe. DWR DMP internal video inspection has found pipe integrity issues. LOF of crossing is between 5 and 6. Crossing will be monitored until funding becomes available to address the issues. No permit was found authorizing this encroachment. CVFPB will need to review crossing to determine owner. The UCIP inspection was completed with LMA representative, H. Latu. (H. Dunn – GEI) 04/14/2014 May need mud and debris cleaning. (P. Andy - DWR UCIP)
 FIELD_STRUCT_DESC: 2 of 2: 48-inch drainage pipe of an unknown material through the levee, 11.5 feet below the crown. Slide gate in corrugated metal riser units on the waterside (WS) slope. Concrete U-shaped headwall on both ends. Flap gates. Grouted rock spillway. [Additional Reference(s): DWR Levee Log, 1992. USACE San Joaquin O&M Manual 611.1, Volume F, (HLM 12.65) corrugated metal pipe listed].

Levee crown looking upstream.

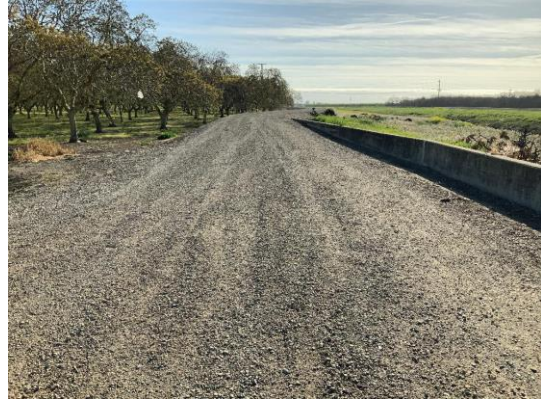
Photo 1 of 3 : UCIP_FA_2022_66972_94611.jpg

Comment Code						
Inspector Comment						
DS_ID:23249 FS_ID:66972 EP_NO: N/A Repair Type: Urgent EVAL Issue: 1, Pipe Integrity Crossing Status: Found UCIP Comments: 03/25/2021 The record has been upgraded from No Action Needed to Urgent. DWR DMP internal video inspection has found pipe integrity issues. LOF of crossing is between 5 and 6. Minor erosion along LS headwall edges. Unknown plastic pipe underground adjacent to LS headwall, does not go through the levee. Crossing will be monitored until funding becomes available to address the issues. No permit was found authorizing this encroachment. CVFPB will need to review crossing to determine owner. The UCIP inspection was completed with LMA representative, H. Latu. (H. Dunn – GEI) 04/14/2014 May need cleaning of pipes. Flood wall on waterside shoulder. (P. Andy - DWR UCIP) FIELD_STRUCT_DESC: 30-inch corrugated metal drainage pipe through the levee, 8.5 feet below the crown. Concrete U-shaped headwall on both ends. Flap gate on the waterside (WS). Grouted intake and spillway. [Additional Reference(s): DWR Levee Log, 1992. USACE San Joaquin O&M Manual 611.1, Volume F, (HLM 12.83)]. FS Date: 3/25/2021

Levee crown looking upstream.

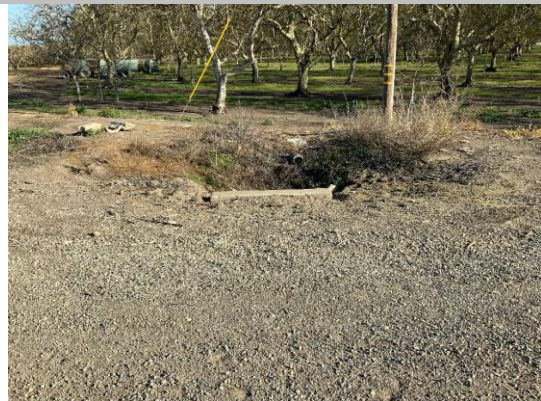
Photo 2 of 3 : UCIP_FA_2022_66972_94613.jpg

LS view: Headwall at toe from crown.

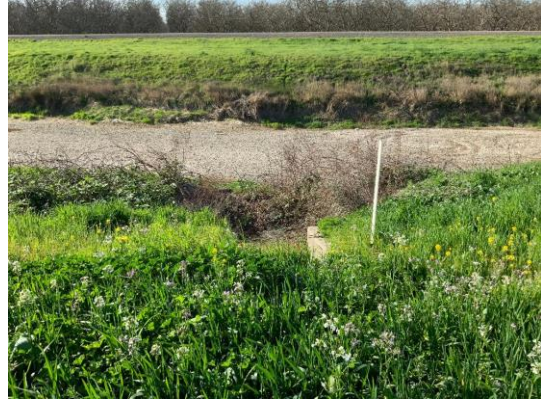
Photo 3 of 3 : UCIP_FA_2022_66972_94617.jpg

WS view: Headwall at toe from crown.

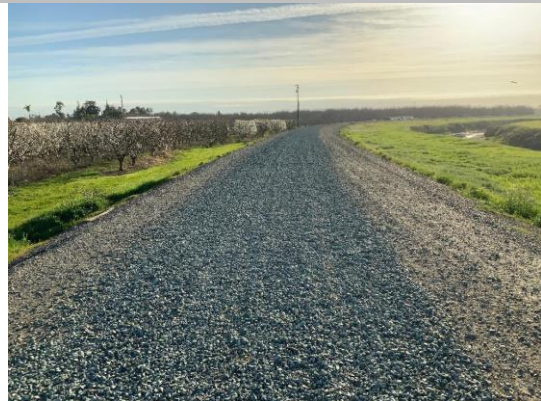
Photo 1 of 3 : UCIP_FA_2022_66975_94652.jpg

DS_ID:23252
 FS_ID:66975
 EP_NO: N/A
 Repair Type: Non-Urgent
 EVAL Issue:
 Crossing Status: Found
 UCIP Comments: 03/25/2021 Pipe status is still Non-Urgent. DWR DMP internal video inspection has not found pipe integrity issues. LOF of crossing is less or equal to 4.0. Recommend next video inspection in 5 years. No permit was found authorizing this encroachment. CVFPB will need to review crossing to determine owner. The UCIP inspection was completed with LMA representative, H. Latu. (H. Dunn – GEI)
 04/14/2014 Needs pipe cleaning. (P. Andy - DWr UCIP)
 FIELD_STRUCT_DESC: 30-inch corrugated metal drainage pipe through the levee, 8.5 feet below the crown. Concrete U-shaped headwalls on both ends. Grouted spillway on the waterside (WS). Flap gate on the WS end. [Additional Reference(s): DWR Levee Log, 1992. USACE San Joaquin O&M Manual 611.1, Volume F, (HLM 13.43)].
 FS Date: 3/25/2021

Levee crown looking upstream.

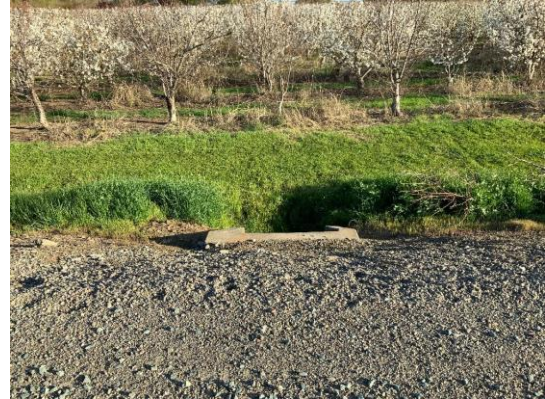
Photo 2 of 3 : UCIP_FA_2022_66975_94654.jpg

LS view: Headwall at toe from crown.

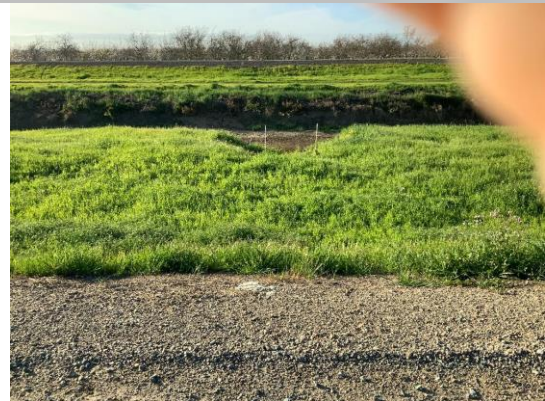
Photo 3 of 3 : UCIP_FA_2022_66975_94648.jpg

WS view: Toe and slope from crown.

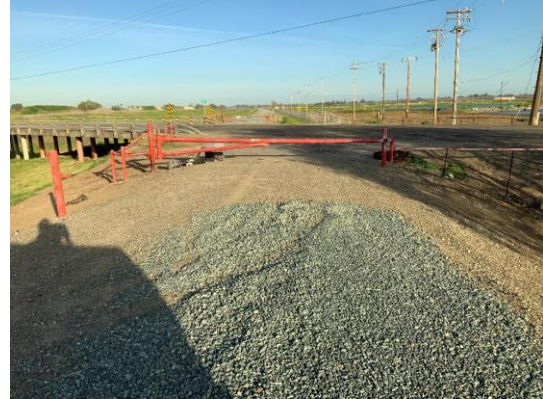
Photo 1 of 3 : UCIP_FA_2022_66977_95094.jpg

Comment Code						
Inspector Comment						
DS_ID:23254 FS_ID:66977 EP_NO: N/A Repair Type: Non-Urgent EVAL Issue: Crossing Status: Found UCIP Comments: 03/25/2021 Pipe status is still Non-Urgent. No permit was found authorizing this encroachment. CVFPB will need to review crossing to determine owner. The UCIP inspection was completed with LMA representative, H. Latu. (H. Dunn – GEI) 04/14/2014 Needs cleaning. (P. Andy - DWR UCIP) FIELD_STRUCT_DESC: 36-inch corrugated metal storm drainage pipe through the levee, 8.5 feet below the crown. Concrete U-shaped headwalls on both ends. Flap gate on the waterside (WS). Grouted spillway. [Additional Reference(s): DWR Levee Log, 1992. USACE San Joaquin O&M Manual 611.1, Volume F, (Station 0+79)]. FS Date: 3/25/2021

Levee crown looking upstream.

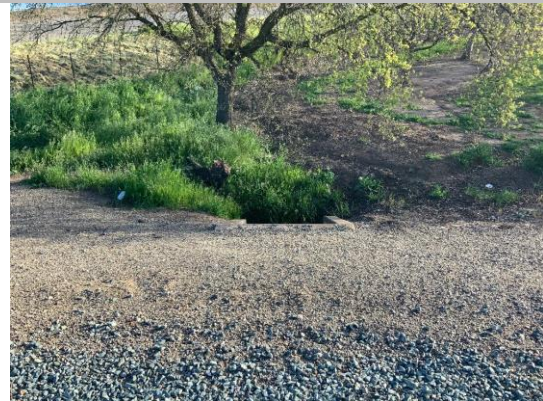
Photo 2 of 3 : UCIP_FA_2022_66977_95095.jpg

LS view: Headwall visible at toe from crown.

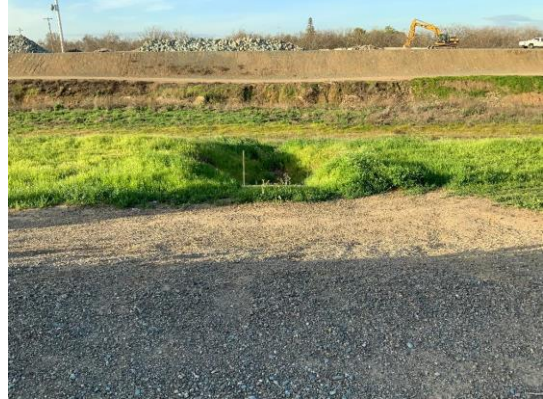
Photo 3 of 3 : UCIP_FA_2022_66977_95098.jpg

WS view: Headwall at toe from crown.

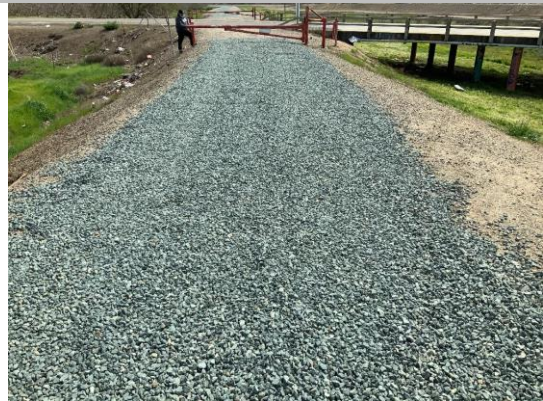
Photo 1 of 3 : UCIP_FA_2022_66979_95108.jpg

DS_ID:23257
 FS_ID:66979
 EP_NO: N/A
 Repair Type: Urgent
 EVAL Issue: 1, Pipe Integrity
 Crossing Status: Found
 UCIP Comments: 03/22/2021 The record has been upgraded from No Action Needed to Urgent. DWR DMP internal video inspection has found pipe integrity issues. LOF of crossing is between 5 and 6. Crossing will be monitored until funding becomes available to address the issues. No permit was found authorizing this encroachment. CVFPB will need to review crossing to determine owner. The UCIP inspection was completed with LMA representative, J. Jauregui. (H. Dunn – GEI)

04/14/2014 May need cleaning. (P. Andy - DWR UCIP)
 FIELD_STRUCT_DESC: 30-inch corrugated metal drainage pipe through the levee, 9.5 feet below the crown. Concrete U-shaped headwalls on both ends. Grouted spillway and intake. Flap gate on the waterside (WS). [Additional Reference(s): DWR Levee Log, 1992. USACE San Joaquin O&M Manual 611.1, Volume F, (HLM 13.79)].
 FS Date: 3/22/2021

Levee crown looking upstream.

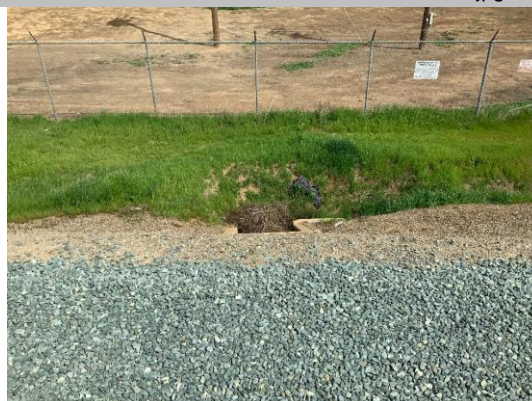
Photo 2 of 3 : UCIP_FA_2022_66979_95109.jpg

LS view: Headwall visible at toe from crown.

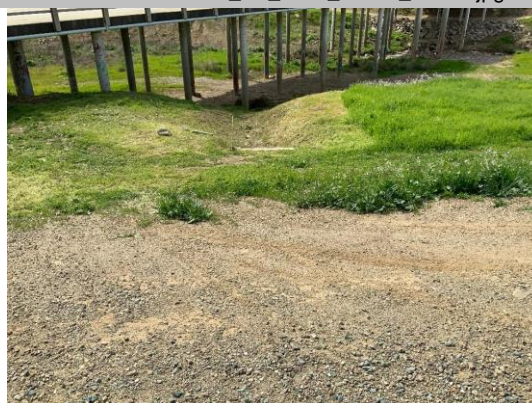
Photo 3 of 3 : UCIP_FA_2022_66979_95112.jpg

WS view: Headwall at toe from crown.

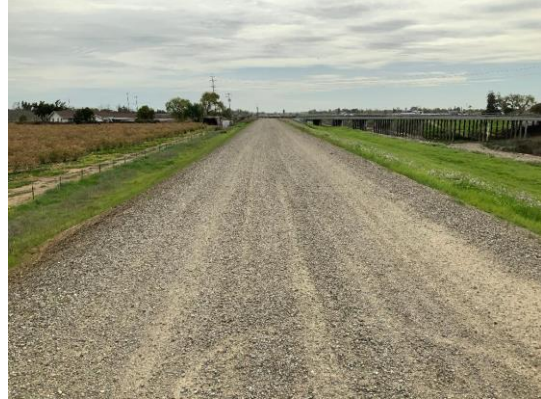
Photo 1 of 3 : UCIP_FA_2022_66990_95201.jpg

Comment Code						
Inspector Comment						
DS_ID:23188 FS_ID:66990 EP_NO: N/A Repair Type: Urgent EVAL Issue: 1, Pipe Integrity Crossing Status: Found UCIP Comments: 03/22/2021 The record has been upgraded from No Action Needed to Urgent. DWR DMP internal video inspection has found pipe integrity issues. LOF of crossing is between 5 and 6. Crossing will be monitored until funding becomes available to address the issues. No permit was found authorizing this encroachment. CVFPB will need to review crossing to determine owner. The UCIP inspection was completed with LMA representative, J. Jauregui. (H. Dunn – GEI) 04/15/2014 May need cleaning. (P. Andy - DWR UCIP) FIELD_STRUCT_DESC: 30-inch corrugated metal drainage pipe through the levee, 9.5 feet below the crown. Concrete U-shaped headwall on both ends. Grouted spillway and intake. Flap gate on the waterside (WS). [Additional Reference(s): DWR Levee Log, 1992. USACE San Joaquin O&M Manual 611.1, Volume F, (HLM 15.58)]. FS Date: 3/22/2021

Levee crown looking upstream.

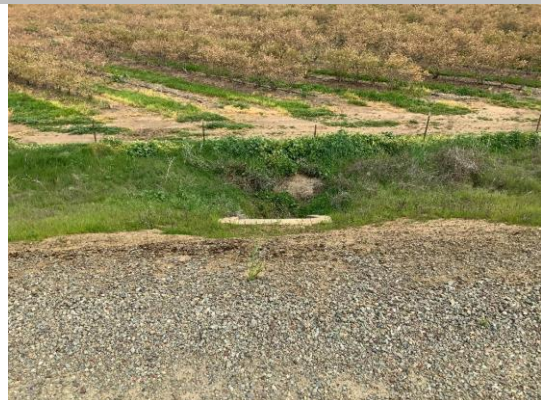
Photo 2 of 3 : UCIP_FA_2022_66990_95202.jpg

LS view: Headwall visible at toe from crown.

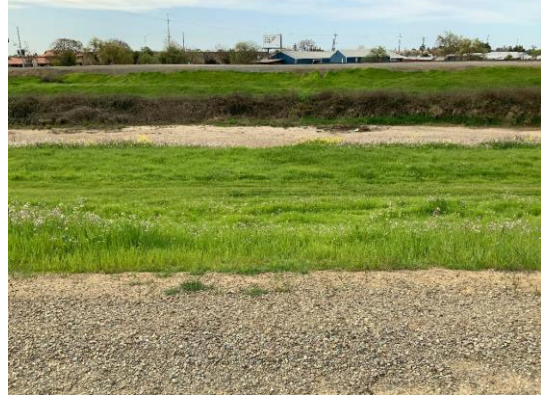
Photo 3 of 3 : UCIP_FA_2022_66990_95205.jpg

WS view: Toe from crown.

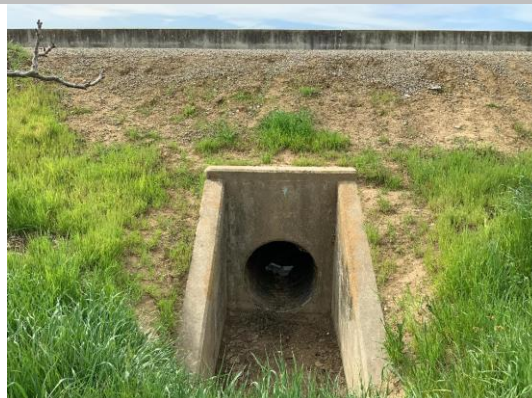
Photo 2 of 3 : UCIP_FA_2022_66992_95210.jpg

DS_ID:23189
 FS_ID:66992
 EP_NO: N/A
 Repair Type: Urgent
 EVAL Issue: 1, Pipe Integrity
 Crossing Status: Found
 UCIP Comments: 03/22/2021 Record updated from No Action Needed to Urgent. DMP internal video inspection has found pipe integrity issues. LOF of crossing is between 5 and 6. Crossing will be monitored until funding becomes available to address the issues. No permit was found authorizing this encroachment. CVFPB will need to review crossing to determine owner. The UCIP inspection was completed with LMA representative, J. Jauregui. (H. Dunn – GEI) 04/15/2014 May need cleaning. (P. Andy - DWR UCIP)
 FIELD_STRUCT_DESC: 30-inch corrugated metal drainage pipe through the levee, 9.5 feet below the crown. Concrete U-shaped headwall on both ends. Grouted spillway and intake. Flap gate.
 [Additional Reference(s): DWR Levee Log, 1992. USACE San Joaquin O&M Manual 611.1, Volume F, (HLM 15.70)].
 FS Date: 3/22/2021

LS view: Headwall at toe.

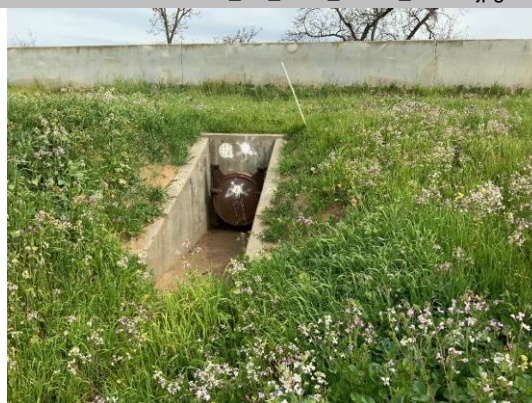
Photo 3 of 3 : UCIP_FA_2022_66992_95213.jpg

WS view: Headwall and flapgate at toe.

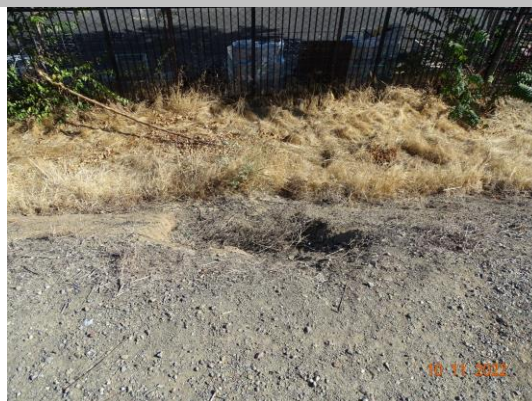
Photo 1 of 1 : FA_2022_NA0017_159_242_20221025_00506.jpg

LM Start	16.84	Rating **	M	Issue No.	242
LM End	16.84	Issue Type +	Ma	Location *	LS
Category	Earthen Levee			GPS Latitude/Longitude	
				Start	End
Item	Erosion / Bank Caving			37.985716 °	37.985716 °
				-121.257788 °	-121.257788 °
DWR ID	DWR_NA0017_15_f_2022_242				
Comment Code					
E2 : Schedule repair of erosion site prior to the next inspection.					
Inspector Comment

View of erosion on the landside slope. Fall 2022

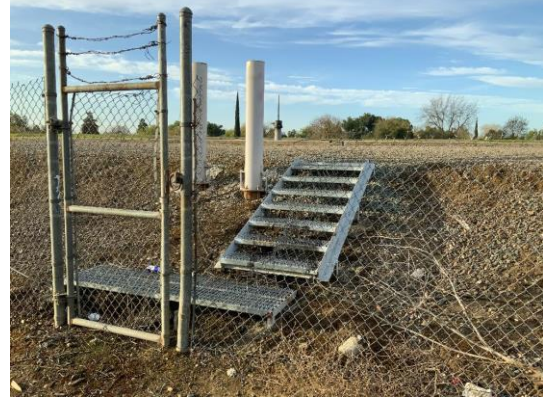
Photo 1 of 3 : UCIP_FA_2022_67012_95334.jpg

Comment Code					
Inspector Comment					
DS_ID:23265 FS_ID:67012 EP_NO: N/A Repair Type: Non-Urgent EVAL Issue: Crossing Status: Found UCIP Comments: 03/22/2021 The record has been upgraded from No Action Needed to Non-Urgent. DWR DMP internal video inspection has not found pipe integrity issues. LOF of crossing is less or equal to 4.0. Recommend next video inspection in 5 years. No permit was found authorizing this encroachment. CVFPB will need to review crossing to determine owner. The UCIP inspection was completed with LMA representative, J. Jauregui. (H. Dunn – GEI) 10/27/2017 This structure is inspected annually under the Structure and Channel Summer Inspection (part of the Levee Inspection Program) conducted by the DWR Flood Project Integrity and Inspection Branch (FPIIB). (DWR UCIP - O. Magana) Adjacent pipes are: two 14-inch pipes through the levee 3.0 feet below the crown. Steel trash rack on landside intake. FIELD_STRUCT_DESC: [Mormon Slough Pumping Plant No. 1] 1 of 3: 30-inch by 30-inch reinforced concrete box drainage culvert through the levee, 17.6 feet below the crown. Slide gate in riser unit on the waterside (WS) slope. Flap gate on the WS end. Concrete U-shaped headwall around all three pipes on the WS. Intake under the pump house on the landside (LS). Steel steps on the LS slope. [Additional Reference(s): DWR Levee Log, 1992. USACE San Joaquin O&M Manual 611.1, Volume F, (HLM 17.74)]. FS Date: 3/22/2021

LS view: Slope from toe, stairs and standpipe.

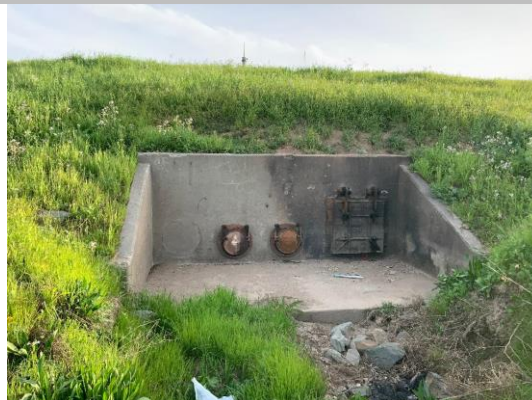
Photo 2 of 3 : UCIP_FA_2022_67012_95331.jpg

WS view: Headwall and flapgates at toe.

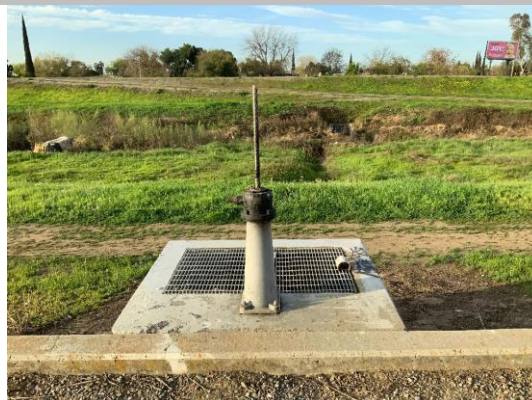
Photo 3 of 3 : UCIP_FA_2022_67012_95335.jpg

WS view: Toe from crown, slidegate in concrete box.

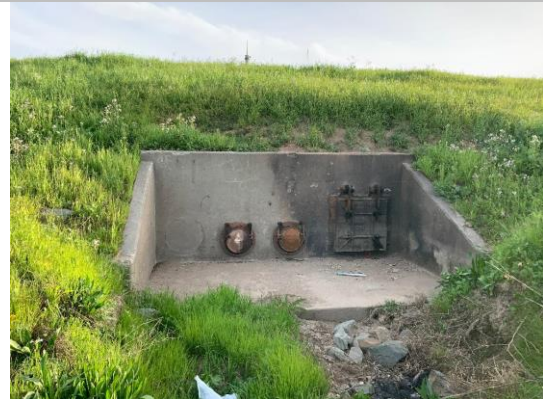
Photo 2 of 3 : UCIP_FA_2022_67013_95343.jpg

Comment Code					
Inspector Comment					
DS_ID:23460 FS_ID:67013 EP_NO: N/A Repair Type: Non-Urgent EVAL Issue: Crossing Status: Found UCIP Comments: 03/22/2021 The record has been upgraded from No Action Needed to Non-Urgent. No permit was found authorizing this encroachment. CVFPB will need to review crossing to determine owner. The UCIP inspection was completed with LMA representative, J. Jauregui. (H. Dunn – GEI) 10/27/2017 This structure is inspected annually under the Structure and Channel Summer Inspection (part of the Levee Inspection Program) conducted by the DWR Flood Project Integrity and Inspection Branch (FPIIB). (DWR UCIP - O. Magana) Adjacent pipe is: 30-inch by 30-inch RC box culvert through the levee 17.6 feet below the crown. Steel trash rack on landside intake. FIELD_STRUCT_DESC: [Mormon Slough Pumping Plant No. 1] 2 of 3: 14-inch steel drainage pipe through the levee, 3 feet below the crown. Siphon breakers in 4-foot high riser units on the landside (LS) shoulder. Flap gates on the waterside (WS) end. Concrete U-shaped headwall around all three pipes on the WS. Pump house on the LS. Steel steps on the LS slope. [Additional Reference(s): DWR Levee Log, 1992. USACE San Joaquin O&M Manual 611.1, Volume F, (HLM 17.74)]. FS Date: 3/22/2021

WS view: Headwall and flapgate.

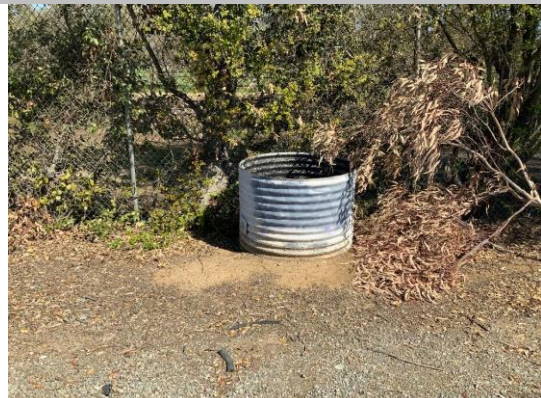
Photo 2 of 3 : UCIP_FA_2022_67018_96287.jpg

LS view: Toe from crown, fence behind CMP riser, cannot access.

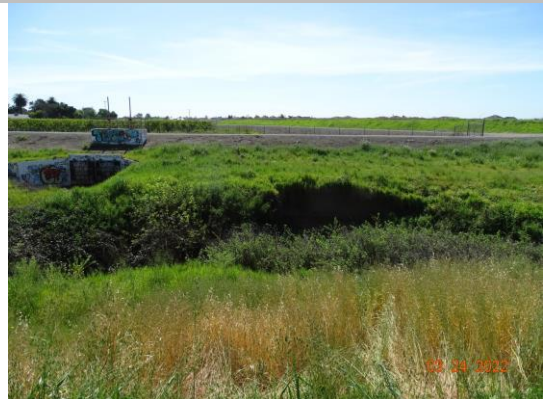
Photo 1 of 3 : SJR2022_NA0017U15RM4.62_1.JPG

LM Start	18.16	Rating **	M	Issue No.	5	
LM End	18.17	Issue Type +	Ma	Location *		
Category	Supplemental			GPS Latitude/Longitude		
				Start	End	
Item	DWR Erosion Survey			37.994649 °	37.994649 °	
				-121.278333 °	-121.278333 °	
DWR ID	NA0017U15RM4.62					
Comment Code						
Inspector Comment						
Site ID: NA0017U15RM4.62 03/24/2022: This site was discovered during the Spring 2022 Levee Inspections. There is a vertical scarp 10 ft tall and 15 ft wide. The erosion is on the left bank of the Calaveras River just upstream of the confluence with Mormon Slough (Stockton Diverting Canal) and 25 ft downstream of a concrete drainage box culvert (DSID 23462).

3/24/2022: View of the erosion from the opposite bank.

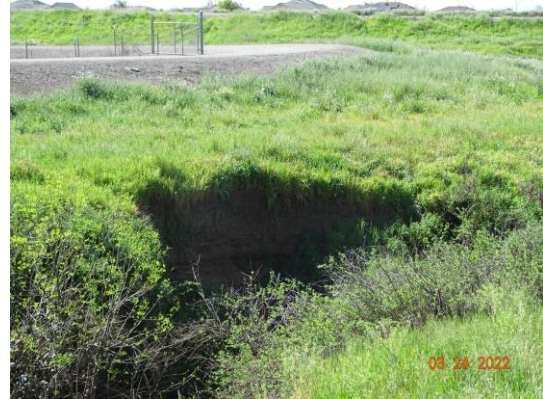
Photo 2 of 3 : SJR2022_NA0017U15RM4.62_2.JPG

3/24/2022: Close-up view of the erosion pocket.

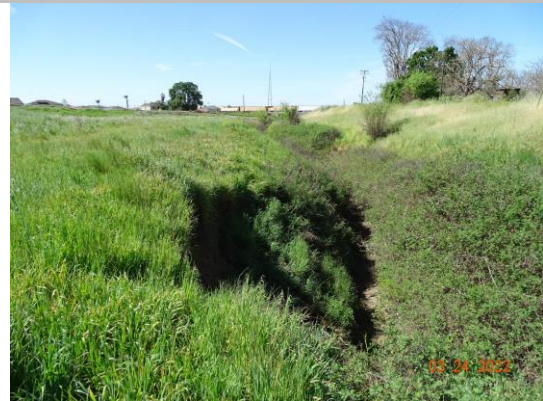
Photo 3 of 3 : SJR2022_NA0017U15RM4.62_3.JPG

3/24/2022: Another view of the erosion.

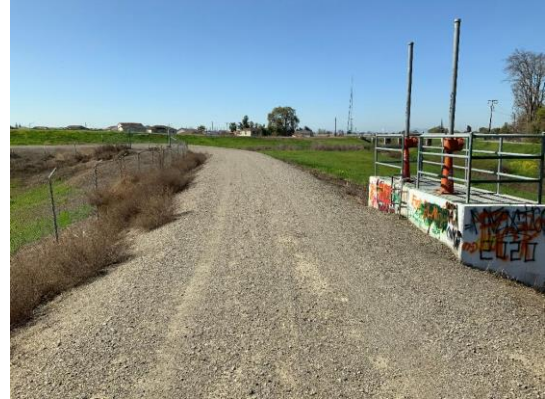
Photo 1 of 3 : UCIP_FA_2022_67020_96302.jpg

Comment Code					
Inspector Comment					
DS_ID:23462 FS_ID:67020 EP_NO: N/A Repair Type: Non-Urgent EVAL Issue: Crossing Status: Found UCIP Comments: 03/12/2021 The record has been upgraded from No Action Needed to Non-Urgent. No permit was found authorizing this encroachment. CVFPB will need to review crossing to determine owner. The UCIP inspection was completed with LMA representative, J. Jauregui. (H. Dunn – GEI) 04/15/2014 Slide gate in a concrete box on landside shoulder. (P. Tariq - DWR UCIP)Concrete headwall and flapgates on waterside. FIELD_STRUCT_DESC: Double 72-inch by 72-inch reinforced concrete box return structure through the levee, at an unknown depth. Slide gate in a concrete box on the landside (LS) shoulder. Concrete headwall and flap gates on the waterside (WS). [Additional Reference(s): USACE San Joaquin O&M Manual 611.1, Volume F, (Station 310+46)]. FS Date: 3/12/2021

Levee crown looking upstream.

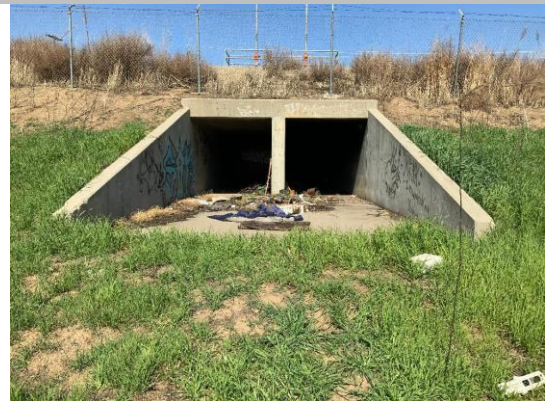
Photo 2 of 3 : UCIP_FA_2022_67020_96298.jpg

LS view: Headwall at toe.

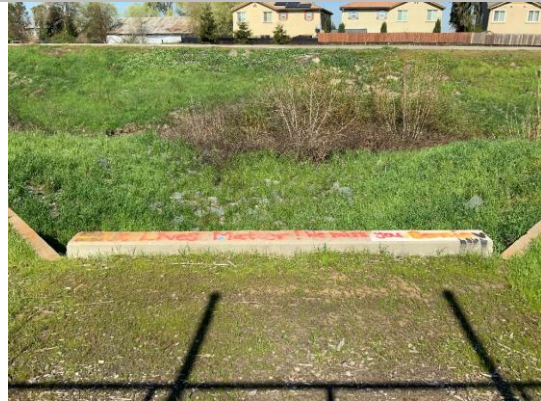
Photo 3 of 3 : UCIP_FA_2022_67020_96304.jpg

WS view: Headwall visible at toe from crown.

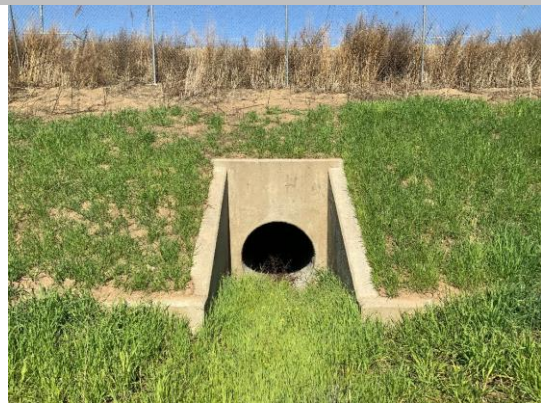
Photo 1 of 3 : UCIP_FA_2022_67021_96316.jpg

DS_ID:23269
FS_ID:67021
EP_NO: N/A
Repair Type: Urgent
EVAL Issue: 1, Pipe Integrity
Crossing Status: Found
UCIP Comments: 03/12/2021 Record updated from Non-Urgent to Urgent. DMP internal video inspection has found pipe integrity issues. LOF of crossing is between 5 and 6. Crossing will be monitored until funding becomes available to address the issues. WS riser is missing the cover. Some minor erosion above the WS headwall and a foot wide hole under the riprap on one outer edge of the headwall, see pics. No permit was found authorizing this encroachment. CVFPB will need to review crossing to determine owner. The UCIP inspection was completed with LMA representative, J. Jauregui. (H. Dunn – GEI)

04/15/2014 Slide gate handle missing. Vegetation on both inlet and outlet box. (P. Tariq - DWR UCIP)
FIELD_STRUCT_DESC: 36-inch corrugated metal drainage pipe through the levee, 15 feet below the crown. Concrete U-shaped headwall on both levee sides. Slide gate in corrugated metal riser unit on the waterside (WS) slope. Flap gate on the WS end. [Additional Reference(s): DWR Levee Log, 1992. USACE San Joaquin O&M Manual 611.1, Volume F, (HLM 18.54)].
FS Date: 3/12/2021

LS view: Headwall at toe.

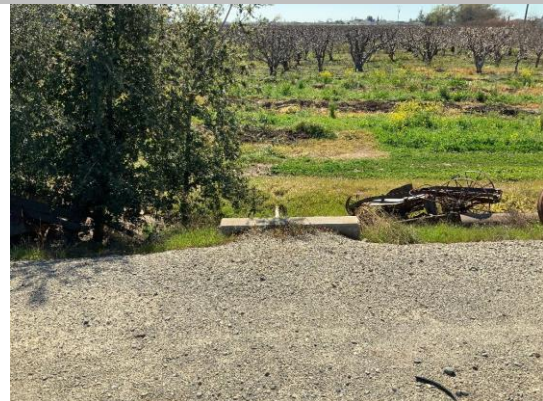
Photo 2 of 3 : UCIP_FA_2022_64907_96322.jpg

LS view: Headwall visible at toe from crown.

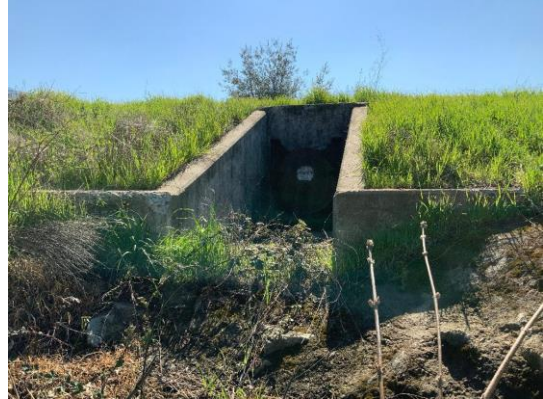
Photo 3 of 3 : UCIP_FA_2022_64907_96327.jpg

WS view: Headwall and flapgate at toe.

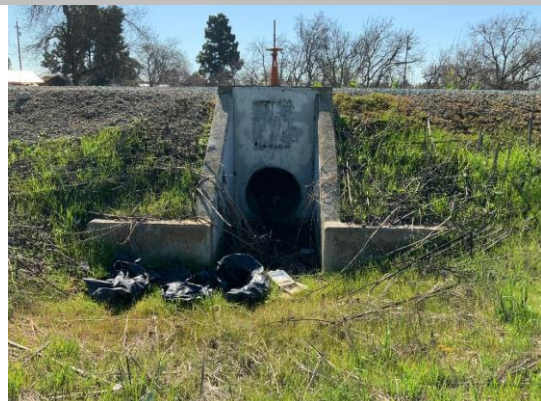
Photo 1 of 3 : UCIP_FA_2022_67023_96341.jpg

Comment Code					
Inspector Comment					
DS_ID:23464 FS_ID:67023 EP_NO: N/A Repair Type: Non-Urgent EVAL Issue: 11, Maintenance Compliance Issue Crossing Status: Found UCIP Comments: 03/12/2021 The record has been upgraded from No Action Needed to Non-Urgent. Vegetation debris and trash seen in LS pipe, recommend cleaning out. No permit was found authorizing this encroachment. CVFPB will need to review crossing to determine owner. The UCIP inspection was completed with LMA representative, J. Jauregui. (H. Dunn – GEI) 04/15/2014 Slide gate in a concrete box on waterside shoulder. (P. tariq - DWR UCIP) FIELD_STRUCT_DESC: 30-inch reinforced concrete storm drainage pipe through the levee, 6 feet below the crown. Slide gate in a concrete box on the waterside (WS) shoulder. [Additional Reference(s): USACE San Joaquin O&M Manual 611.1, Volume F, (Station 345+65)]. FS Date: 3/12/2021

LS view: Headwall at toe.
