**Flood Control Project Maintenance
Levee Inspections**

Maintenance Issue Types Only, Levee Inspection Report By Mile - Fall 2022

San Joaquin County Flood Control and Water Conservation District

Waterway	Bank	Unit Miles	Inspection Start/End	Inspector
Unit No. 01 Littlejohn Creek	Left	2.59	10/13/2022 10/13/2022	Alberto De Leon

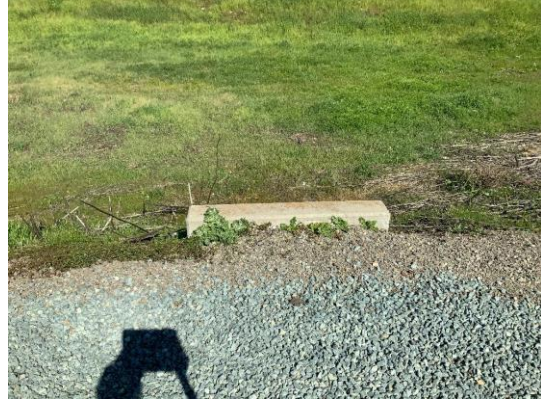
Photo 2 of 3 : UCIP_FA_2022_67023_96340.jpg

LS view: Headwall visible at toe from crown.

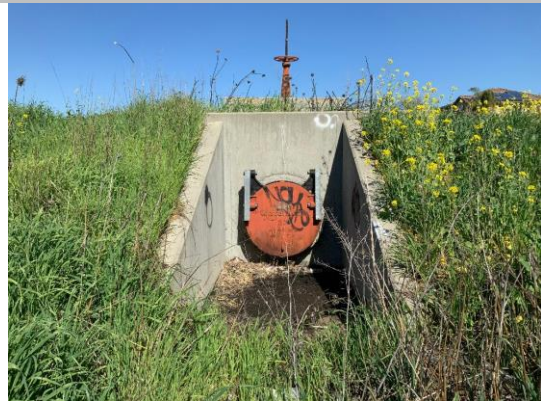
Photo 3 of 3 : UCIP_FA_2022_67023_96337.jpg

WS view: Headwall, flapgate, and slidegate at toe.

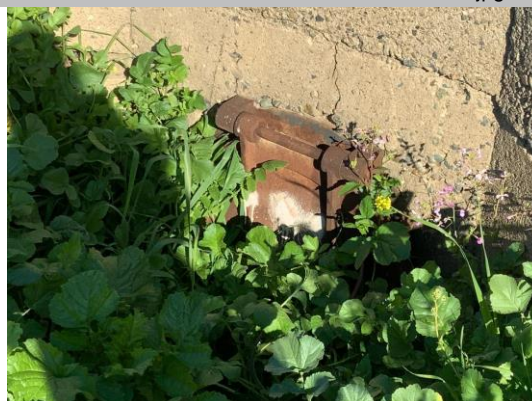
Photo 2 of 3 : UCIP_FA_2022_67031_96409.jpg

WS view: Close up of headwall and flapgate, overgrown with vegetation.

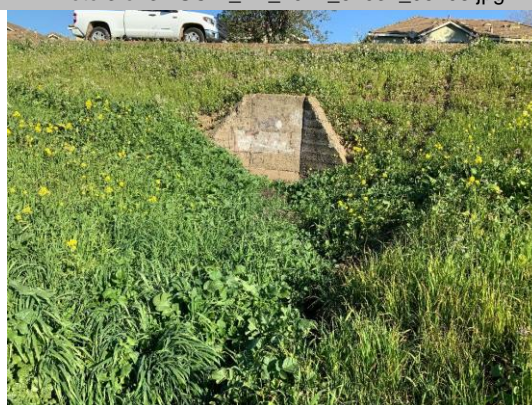
Photo 3 of 3 : UCIP_FA_2022_67031_96408.jpg

WS view: Headwall at toe, overgrown with vegetation.

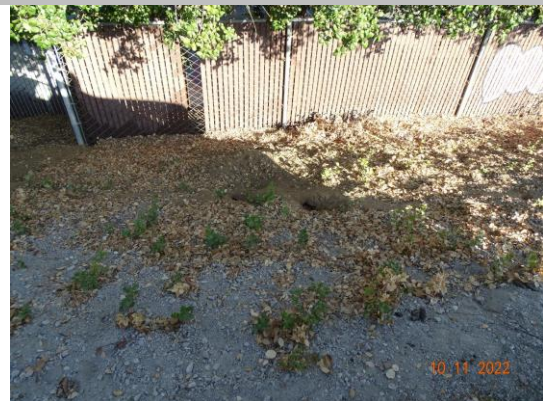
Photo 1 of 1 : FA_2022_NA0017_159_213_20221025_00498.jpg

LM Start	21.81	Rating **	U	Issue No.	213
LM End	21.82	Issue Type +	Ma	Location *	LS
Category	Earthen Levee			GPS Latitude/Longitude	
				Start	End
Item	Animal Control			37.982668 °	37.982547 °
				-121.312932 °	-121.313118 °
DWR ID	DWR_NA0017_15_f_2022_213				
Comment Code					
A1 : Exterminate rodents and backfill and compact or grout burrows.					
Inspector Comment

View of large animal burrow on the landside slope. Fall 2022

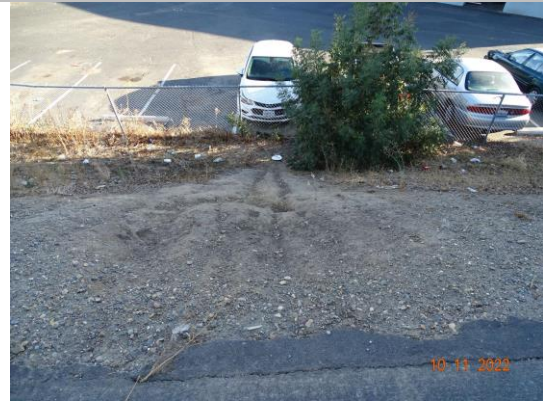
Photo 1 of 1 : FA_2022_NA0017_159_134_20221025_00493.jpg

LM Start	22.26	Rating **	M	Issue No.	134
LM End	22.26	Issue Type +	Ma	Location *	LS
Category	Earthen Levee			GPS Latitude/Longitude	
				Start	End
Item	Erosion / Rills			37.980937 °	37.980937 °
				-121.319809 °	-121.319809 °
DWR ID	DWR_NA0017_15_s_2020_134				
Comment Code					
E5 : Schedule repair of rills prior to the next inspection.					
Inspector Comment

View of rills on the landside slope. Fall 2022

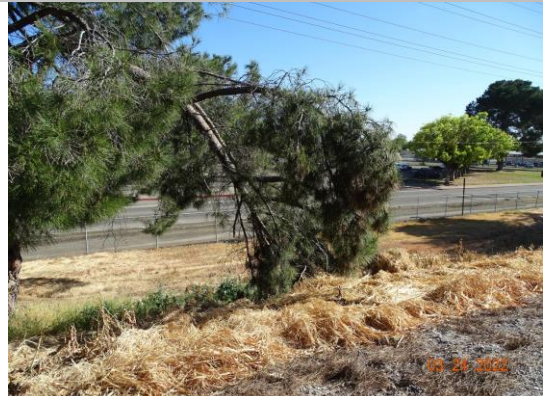
Photo 1 of 1 : FA_2022_NA0017_159_190_20220919_00048.jpg

LM Start	22.55	Rating **	M	Issue No.	190
LM End	22.55	Issue Type +	Ma	Location *	LS
Category	Earthen Levee			GPS Latitude/Longitude	
				Start	End
Item	Trim / Thin Trees			37.981920 °	37.981920 °
				-121.324943 °	-121.324943 °
DWR ID	DWR_NA0017_15_f _ 2019_190				
Comment Code					
T1 : Trim and thin trees to at least five feet above ground level to allow visibility of the ground and room to flood fight.					
Inspector Comment

View of fallen tree branch on landside slope. Spring 2022

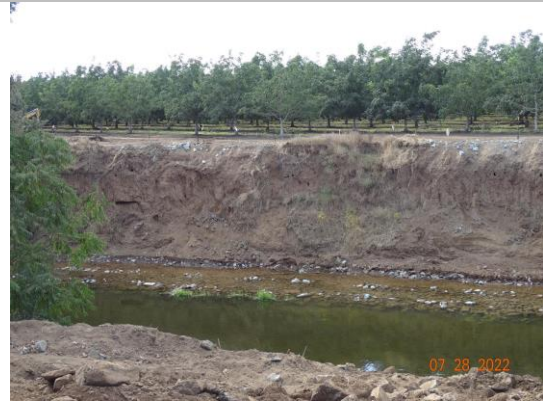
Photo 1 of 2 : SJR2022_NA0017U16RM23.35_2.JPG

Comment Code						
Inspector Comment						
Site ID: NA0017U16RM23.35 *This area is patrol road only and therefore the site is not rated 07/28/2022: The site is being repaired. 06/23/2021: From 2018 to present, no significant changes were observed during the annual survey. 08/30/2017: The erosion has cut further into the river bank. Newly collapsed material is observed at the bottom of the erosion site. 08/16/2016: The erosion site was found progressed with signs of bank slipping. 08/12/2015: The erosion progressed at the site. Newly collapsed material is observed at the bottom of the erosion. 08/20/2014: The erosion at the site has worsened. The erosion increased in both length and in height. 09/12/2013: Site has been visited and signs of new erosion are visible. 08/22/2012: The erosion was surveyed and documented for monitoring purpose. There is no levee structure on the site, only high ground protecting the land behind.

7/28/2022: View of the erosion from the opposite bank. Repairs are in progress.

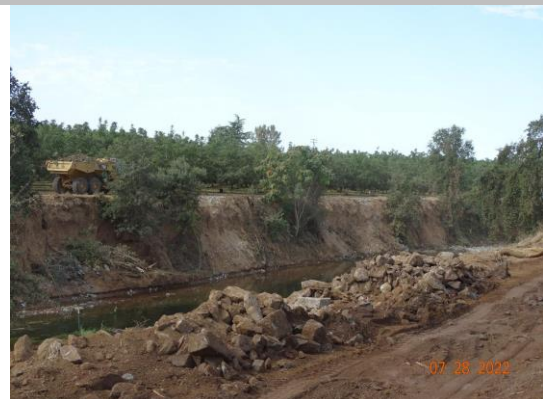
Photo 2 of 2 : SJR2022_NA0017U16RM23.35_3.JPG

7/28/2022: Another view of the site being repaired.

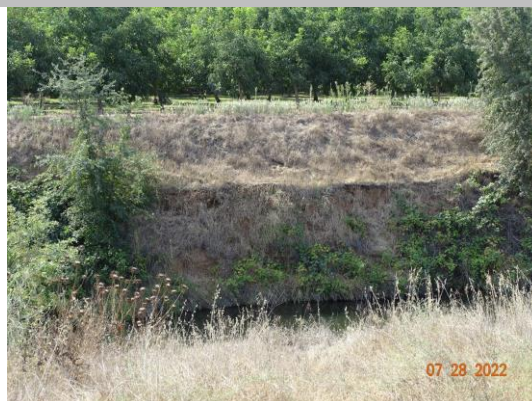
Photo 1 of 2 : SJR2022_NA0017U16RM22.74_2.JPG

*This area is patrol road only and therefore the site is not rated
07/28/2022: From 2013 to present, no significant changes were observed during the annual survey. The erosion length was updated to 180 ft based on more accurate field measurements.

08/22/2012: The erosion was surveyed and documented for monitoring purpose. There is no levee structure on the site, only high ground protecting the land behind. There is a drainage pipe at the site, which might have caused the problem at one pocket erosion.

7/28/2022: View of the erosion from the opposite bank.

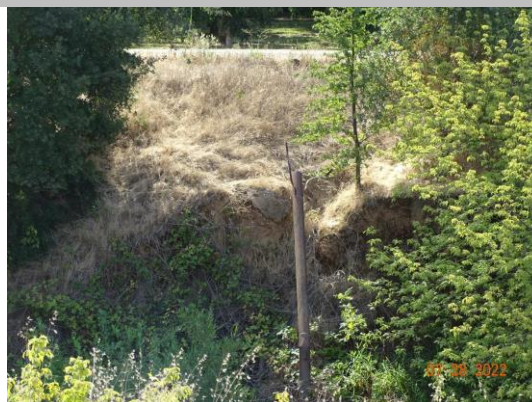
Photo 2 of 2 : SJR2022_NA0017U16RM22.74_3.JPG

7/28/2022: Another view of the erosion.

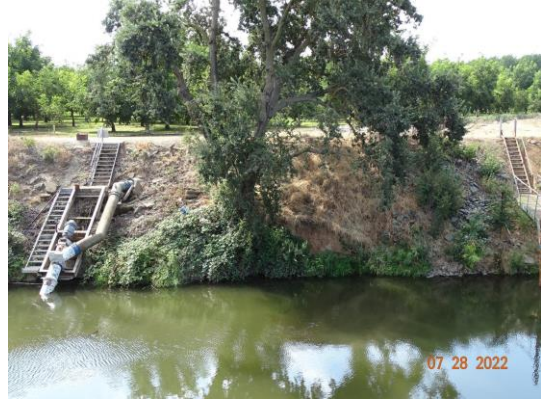
Photo 1 of 1 : SJR2022_NA0017U16RM22.58_2.JPG

Comment Code						
Inspector Comment						
Site ID: NA0017U16RM22.58						
*This area is patrol road only and therefore the site is not rated						
07/28/2022: From 2021 to present, no significant changes were						
observed during the annual survey.						
07/23/2020: The site has less vegetation and more bare soil on the						
upper slope since the previous inspection. Some sloughing was also						
observed.						
08/28/2019: From 2013 to 2019, no significant changes were observed						
during the annual survey.						
08/22/2012: The erosion is at the outside corner of a river bend, and						
next to a tree at the levee toe. Irrigation structure presents at the site.						
There is no levee structure on site.

7/28/2022: View of the erosion from the opposite bank.

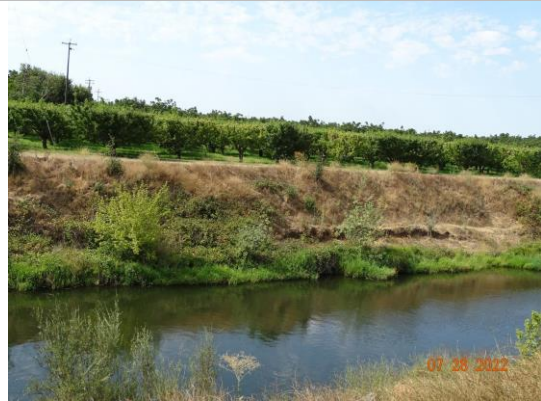
Photo 1 of 2 : SJR2022_NA0017U16RM22.16_2.JPG

LM Start	1.54	Rating **	A/W	Issue No.	41
LM End	1.56	Issue Type +	Ma	Location *	
Category	Supplemental			GPS Latitude/Longitude	
				Start	End
Item	DWR Erosion Survey			38.039394 °	38.039394 °
				-121.035289 °	-121.035289 °
DWR ID	NA0017U16RM22.16				
Comment Code					
Inspector Comment					
Site ID: NA0017U16RM22.16					
*This area is patrol road only and therefore the site is not rated					
07/28/2022: The length was increased to 100 ft. Otherwise, no					
significant changes were observed since the previous inspection.					
06/23/2021: The site was discovered during the field survey. The					
erosion is just downstream of a weir. There is some caving and					
sloughing visible on the slope and a large, 1.5-ft long and 0.8-ft wide					
rodent hole at the toe.

7/28/2022: View of the erosion from the opposite bank.

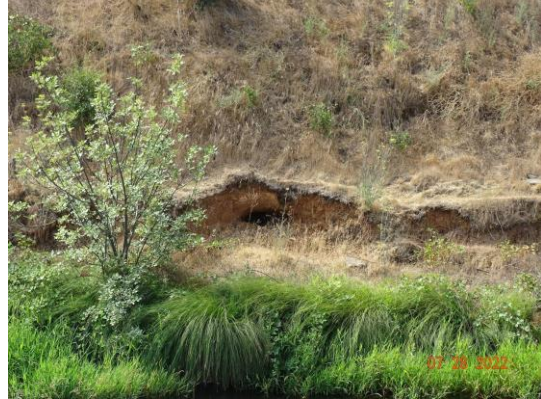
Photo 2 of 2 : SJR2022_NA0017U16RM22.16_3.JPG

7/28/2022: View of the erosion and large animal hole in the center at the toe.

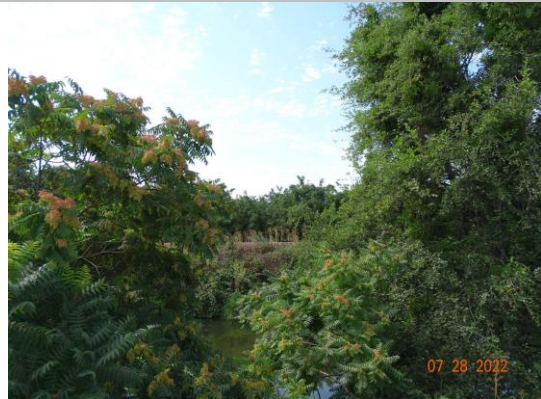
Photo 1 of 2 : SJR2022_NA0017U16RM22.15_2.JPG

*This area is patrol road only and therefore the site is not rated
07/28/2022: From 2013 to present, no significant changes were observed during the annual survey. This site was combined with a site immediately downstream (NA0017U016RM22.01) and the erosion length increased to 50 ft.

08/22/2012: The berm is estimated at 10 ft. Dense vegetation on site. There is no levee structure on site.

7/28/2022: View of the erosion from the opposite bank.

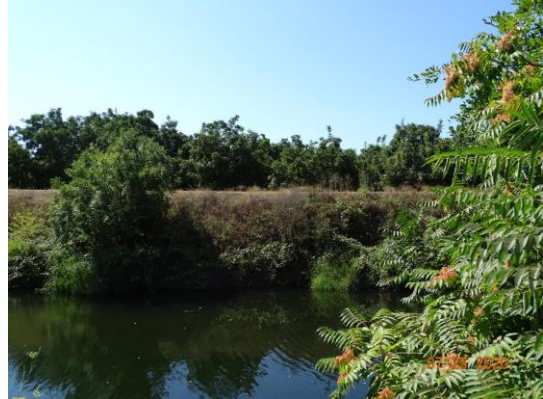
Photo 2 of 2 : SJR2022_NA0017U16RM22.01_02.JPG

7/23/2020: View of the erosion from the opposite bank.

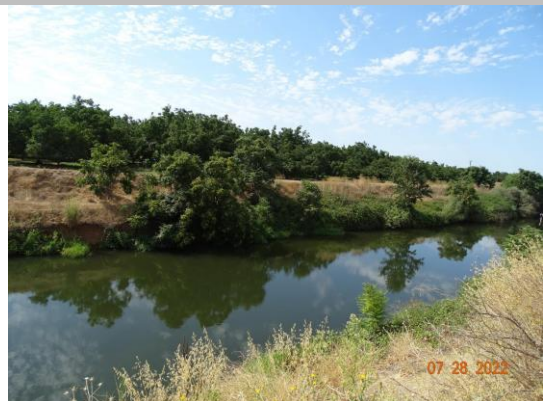
Photo 1 of 2 : SJR2022_NA0017U16RM21.95_3.JPG

*This area is patrol road only and therefore the site is not rated
07/28/2022: From 2013 to present, no significant changes were observed during the annual survey. The scarp is nearly vertical at the toe. This site was combined with a site immediately downstream (NA0017U16RM21.94) and the erosion length increased to 320 ft.
08/22/2012: The erosion is covered by dense vegetation. There is no levee structure on site.

7/28/2022: View of the erosion from the opposite bank.

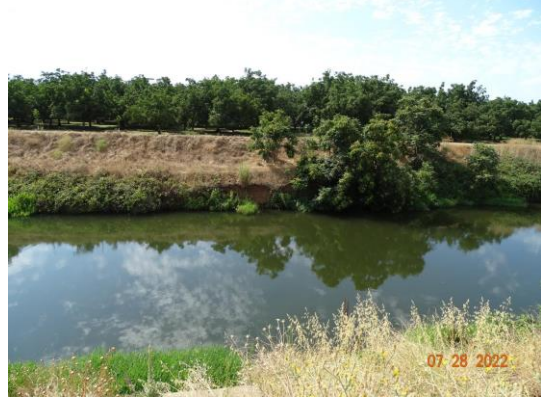
Photo 2 of 2 : SJR2022_NA0017U16RM21.95_2.JPG

7/28/2022: View of the erosion a little further upstream.

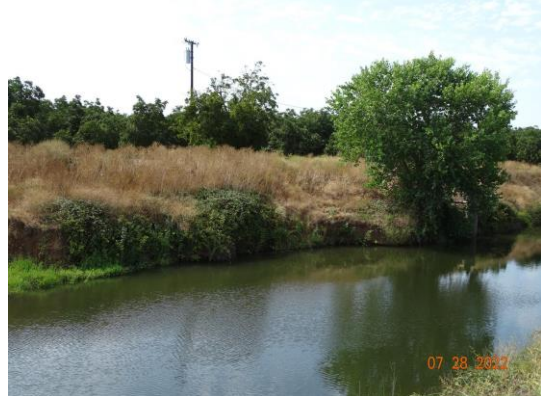
Photo 1 of 2 : SJR2022_NA0017U16RM21.05_2.JPG

*This area is patrol road only and therefore the site is not rated
 07/28/2022: From 2013 to present, no significant changes were observed during the annual survey. The erosion length was updated to 290 ft in 2021 based on more accurate field measurements and the site was combined with a site immediately downstream (NA0017U16RM21.03). The erosion is just up and downstream of an irrigation pipe crossing (see DSIDs 23321/24938).
 08/22/2012: Berm width is estimated as 5 ft. There is no levee structure on site.

7/28/2022: View of the erosion just upstream of the pipe crossing.

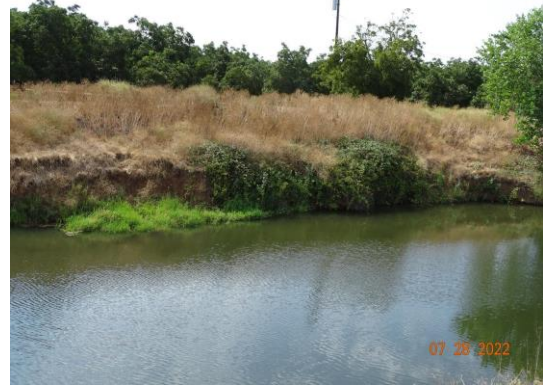
Photo 2 of 2 : SJR2022_NA0017U16RM21.05_3.JPG

7/28/2022: Another view of the erosion.

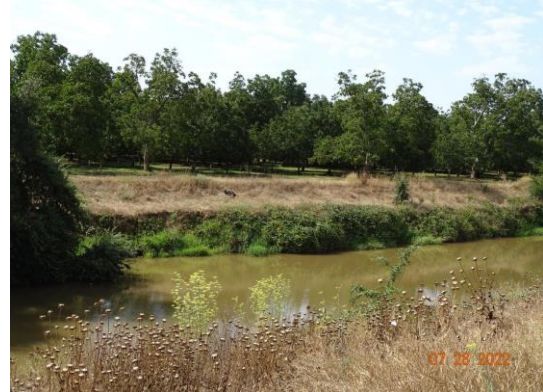
Photo 1 of 1 : SJR2022_NA0017U16RM20.71_3.JPG

*This area is patrol road only and therefore the site is not rated
07/28/2022: From 2013 to present, no significant changes were observed during the annual survey. The erosion length was updated to 75 ft based on more accurate field measurements.
08/22/2012: Site is covered with dense vegetation. There is no levee structure on site.

7/28/2022: View of the erosion from the opposite bank.

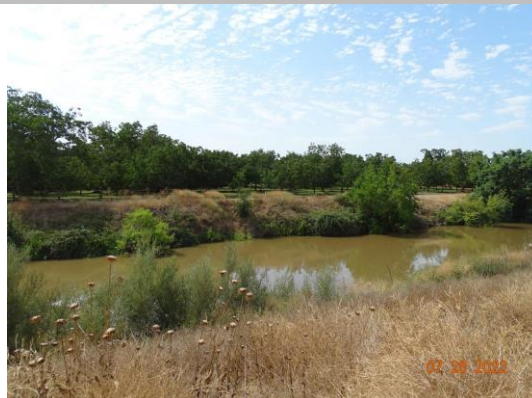
Photo 1 of 2 : SJR2022_NA0017U16RM20.62_4.JPG

LM Start	2.29	Rating **	A/W	Issue No.	33
LM End	2.31	Issue Type +	Ma	Location *	
Category	Supplemental			GPS Latitude/Longitude	
				Start	End
Item	DWR Erosion Survey			38.032202 °	38.032202 °
				-121.045226 °	-121.045226 °
DWR ID	NA0017U16RM20.62				
Comment Code					
Inspector Comment					
Site ID: NA0017U16RM20.62					
*This area is patrol road only and therefore the site is not rated					
07/28/2022: From 2013 to present, no significant changes were					
observed during the annual survey. The erosion length was updated to					
120 ft based on more accurate field measurements.					
08/22/2012: The erosion was first reported in the 2012 spring levee					
inspection report. There is no levee structure on site.

7/28/2022: View of the erosion from the opposite bank.

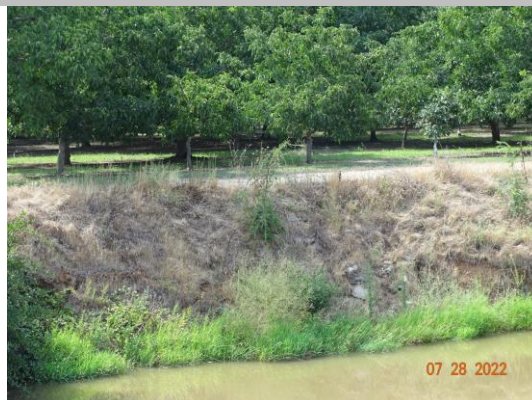
Photo 2 of 2 : SJR2022_NA0017U16RM20.62_2.JPG

7/28/2022: Close-up view of the erosion.

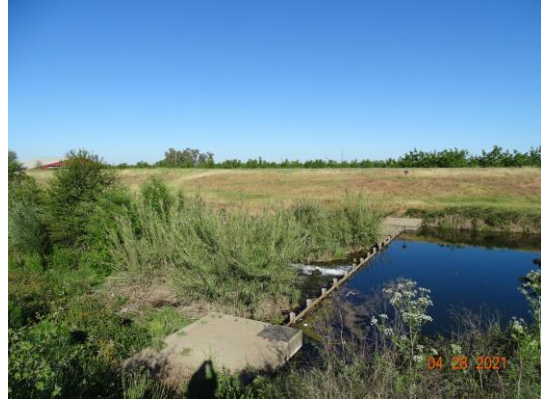
Photo 1 of 1 : FA_2022_NA0017_160_247_20220919_00080.jpg

LM Start	2.44	Rating **	M	Issue No.	247
LM End	2.44	Issue Type +	Ma	Location *	WS
Category	Rivers, Channels & Designated Floodways			GPS Latitude/Longitude	
				Start	End
Item	Vegetation & Obstructions			38.030668 °	38.030668 °
				-121.046842 °	-121.046842 °
DWR ID	DWR_NA0017_16_f_2017_247				
Comment Code					
Inspector Comment					
Arundo growing in the channel may decrease the capacity of the channel.

View of Arundo within the channel looking downstream. Spring 2021

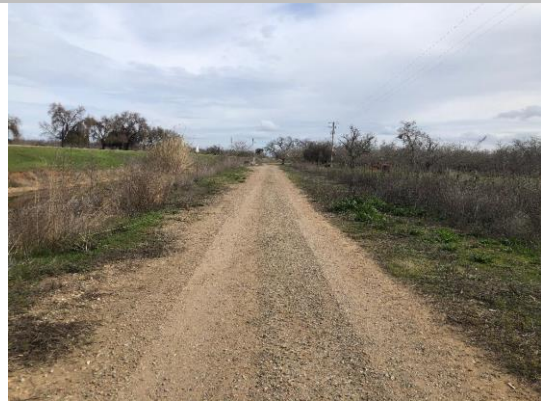
Photo 1 of 3 : UCIP_FA_2022_65963_95459.jpg

Comment Code					
Inspector Comment					
DS_ID:23323 FS_ID:65963 EP_NO: N/A Repair Type: Non-Urgent EVAL Issue: Crossing Status: Found UCIP Comments: 03/09/2021 Record remains Non-Urgent. Unit 16 – Mormon Slough (CLM 0 to 11) is considered a patrol road/high ground area with no defined levee prism, any issue found between CLM 0 to 11 of Unit 16 will be considered a maintenance issue, or an unauthorized encroachment, or an abandoned encroachment. Current condition of pipe crossing does not impede access to patrol road/high ground area. Access limited to pipe inlet due to fencing. Pipe inlet appears bent and partly filled with sediment. Briar bush and vegetation overgrowth limiting visibility of WS slope. No permit has been identified authorizing utility. CVFPB will need to review crossing to determine owner. The UCIP inspection was completed with LMA representative, H. Latu. (N. Cholewinski - GEI)04/24/2014 Heavy vegetation obscuring outlet. remove vegetation and verify flapgate installed. (W. Wylie - DWR UCIP) FIELD_STRUCT_DESC: 18-inch corrugated metal drainage pipe, 3 feet below the roadway. Grouted spillway. [Additional Reference(s): DWR Levee Log, 1992. USACE San Joaquin O&M Manual 611.1, Volume F, (HLM 2.52)]. FS Date: 3/9/2021

Crossing Overview

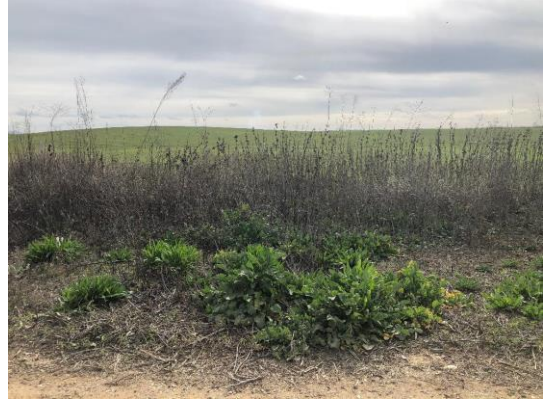
Photo 2 of 3 : UCIP_FA_2022_65963_95460.jpg

LS View

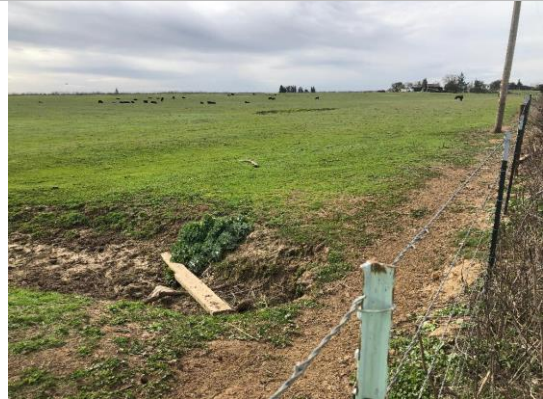
Photo 3 of 3 : UCIP_FA_2022_65963_95461.jpg

LS View: Pipe inlet visible at LS.

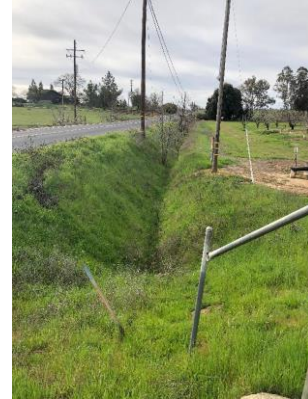
Photo 2 of 3 : UCIP_FA_2022_65964_95453.jpg

LS View: Pipe in drainage ditch at LS.

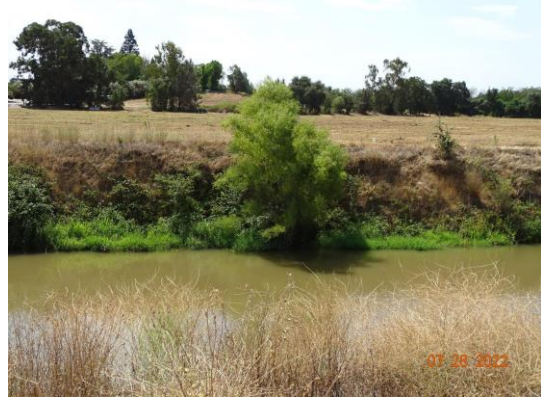
Photo 1 of 1 : SJR2022_NA0017U16RM20.00_2.JPG

LM Start	2.92	Rating **	A/W	Issue No.	22
LM End	2.94	Issue Type +	Ma	Location *	
Category	Supplemental			GPS Latitude/Longitude	
				Start	End
Item	DWR Erosion Survey			38.026372 °	38.026372 °
				-121.053819 °	-121.053819 °
DWR ID	NA0017U16RM19.95				
Comment Code					
Inspector Comment					
Site ID: NA0017U16RM19.95					
*This area is patrol road only and therefore the site is not rated					
07/28/2022: From 2013 to present, no significant changes were					
observed during the annual survey. The erosion length was updated to					
110 ft based on more accurate field measurements. Additionally, the					
coordinates, LM, and RM were updated and the Site ID changed from					
NA0017U16RM20 to NA0017U16RM19.95.					
08/22/2012: Site comprised of series of pocket and scarp erosions.					
Some of erosions are covered by grass or shrubs. There is no levee					
structure on site.

7/28/2022: View of the erosion from the opposite bank.

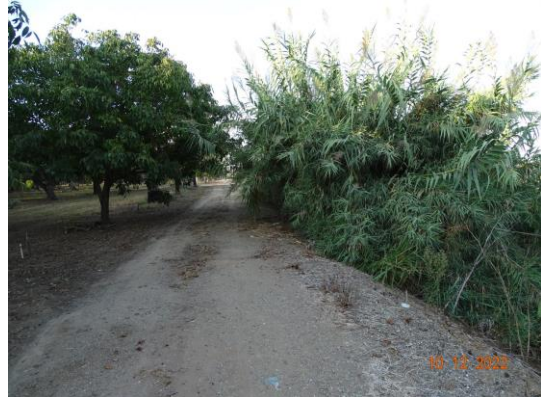
Photo 1 of 1 : FA_2022_NA0017_160_152_20221024_00628.jpg

LM Start	3.47	Rating **	U	Issue No.	152
LM End	3.47	Issue Type +	Ma	Location *	WS
Category	Earthen Levee			GPS Latitude/Longitude	
				Start	End
Item	Vegetation			38.021032 °	38.021032 °
				-121.061085 °	-121.061085 °
DWR ID	DWR_NA0017_16_f_2013_152				
Comment Code					
V2 : Remove the wild growth and woody vegetation other than native grasses from the levee slopes.					
Inspector Comment					
Arundo is encroaching onto the patrol road limiting access.

View of Arundo on the waterside shoulder. Fall 2022

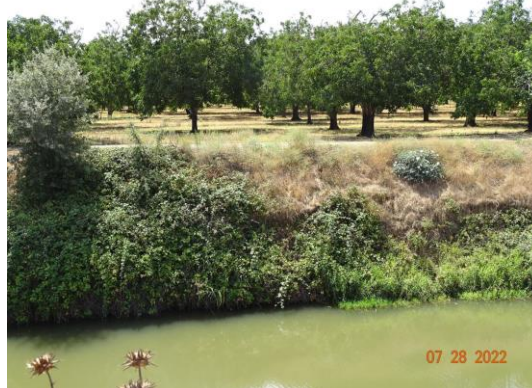
Photo 1 of 1 : SJR2022_NA0017U16RM19.29_2.JPG

LM Start	3.61	Rating **	A/W	Issue No.	38
LM End	3.62	Issue Type +	Ma	Location *	
Category	Supplemental			GPS Latitude/Longitude	
				Start	End
Item	DWR Erosion Survey			38.019642 °	38.019642 °
				-121.062917 °	-121.062917 °
DWR ID	NA0017U16RM19.29				
Comment Code					
Inspector Comment					
Site ID: NA0017U16RM19.29					
*This area is patrol road only and therefore the site is not rated					
07/28/2022: From 2015 to present, no significant changes were					
observed during the annual survey. The erosion length was updated to					
60 ft based on more accurate field measurements.The vegetation					
growth has increased.					
08/20/2014: A pocket erosion was found near the water's edge.

7/28/2022: View of the erosion from the opposite bank.

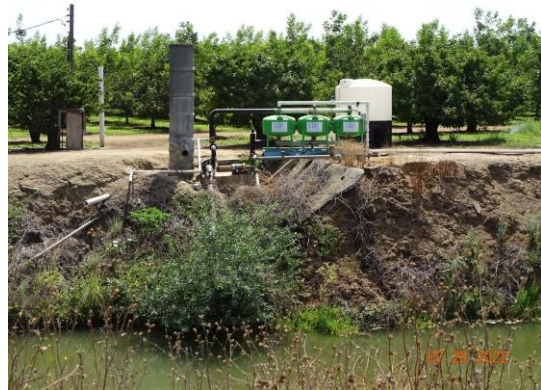
Photo 1 of 1 : SJR2022_NA0017U16RM18.69_3.JPG

Comment Code					
Inspector Comment					
Site ID: NA0017U16RM18.69					
*This area is patrol road only and therefore the site is not rated					
07/28/2022: From 2018 to present, no significant changes were					
observed during the annual survey. The erosion length was updated to					
50 ft based on more accurate field measurements. The site is located					
just upstream of an irrigation pipe crossing (DSIDs 23328/24945).					
08/30/2017: New erosion observed at the site, under the irrigation pipe.					
08/16/2016: From 2013 to present, no significant changes were					
observed during the annual survey.					
08/22/2012: An irrigation pipe is present at the site, but probably did not					
cause the erosion. There is no levee structure on site.

7/28/2022: View of the erosion from the opposite bank.

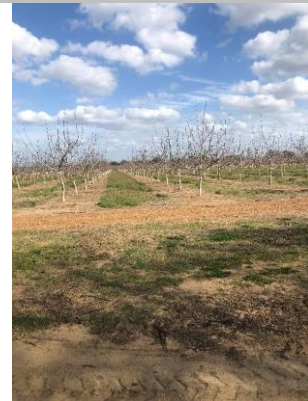
Comment Code						
Inspector Comment						
DS_ID:23447 FS_ID:66022 EP_NO: N/A Repair Type: Non-Urgent EVAL Issue: Crossing Status: Not Found UCIP Comments: 03/08/2021 Record updated from No Action Needed to Non-Urgent. Unit 16 – Mormon Slough (CLM 0 to 11) is considered a patrol road/high ground area with no defined levee prism, any issue found between CLM 0 to 11 of Unit 16 will be considered a maintenance issue, or an unauthorized encroachment, or an abandoned encroachment. Geophysical study indicates possible presence of pipe through levee. Owner needs to coordinate with the CVFPB to remove or abandon crossing according to Title 23 requirements. Current condition of pipe crossing does not impede access to patrol road/high ground area. Utility not found during inspection. Grout apron observed on WS slope, approximately 50 feet upstream of geophysics location. No permit was found authorizing this encroachment. CVFPB will need to review crossing to determine owner. The UCIP inspection was completed with LMA representative, H. Latu. (N. Cholewinski - GEI) FIELD_STRUCT_DESC: 18-inch corrugated metal drainage pipe through the roadway, 3-foot invert below the surface. Drain inlet ungated. [Additional Reference(s): USACE San Joaquin O&M Manual 611.1, Volume F, (HLM 4.33)]. FS Date: 3/8/2021

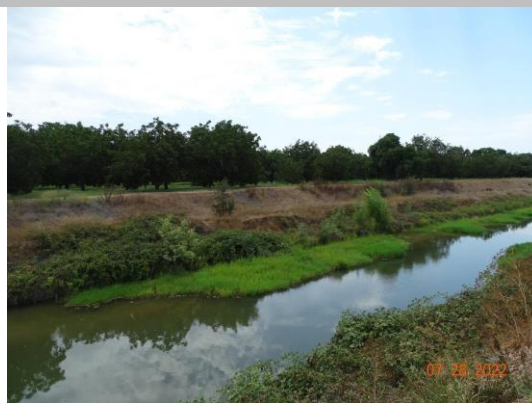
Photo 1 of 2 : SJR2022_NA0017U16RM17.81_2.JPG

LM Start	5.33	Rating **	A/W	Issue No.	25
LM End	5.37	Issue Type +	Ma	Location *	
Category	Supplemental			GPS Latitude/Longitude	
				Start	End
Item	DWR Erosion Survey			37.997720 °	37.997720 °
				-121.077807 °	-121.077807 °
DWR ID	NA0017U16RM17.81				
Comment Code					
Inspector Comment					
Site ID: NA0017U16RM17.81					
*This area is patrol road only and therefore the site is not rated					
07/28/2022: From 2013 to present, no significant changes were					
observed during the annual survey. The erosion length was updated to					
210 ft based on more accurate field measurements.					
08/22/2012: The site is located at the opposite river bank of E. Tobacco					
Road. There is no levee structure on site.

7/28/2022: View of the erosion from the opposite bank.

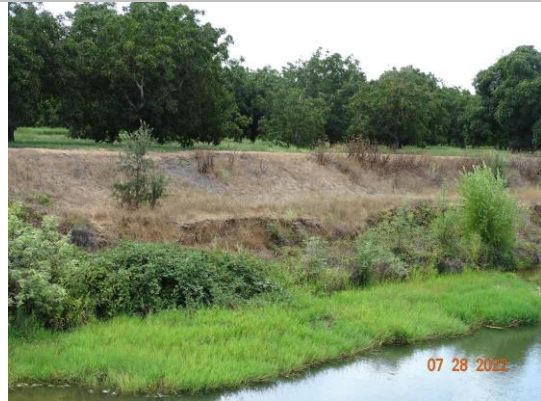
Photo 2 of 2 : SJR2022_NA0017U16RM17.81_3.JPG

7/28/2022: Another view of the erosion.

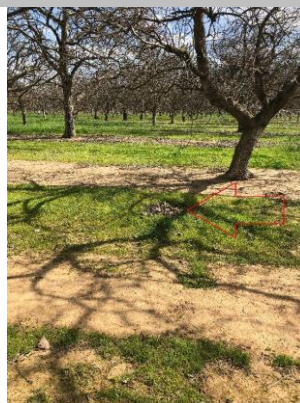
Photo 2 of 3 : UCIP_FA_2022_66029_95183.jpg

Comment Code						
Inspector Comment						
DS_ID:23332 FS_ID:66029 EP_NO: N/A Repair Type: Non-Urgent EVAL Issue: 11, Maintenance Compliance Issue Crossing Status: Found UCIP Comments: 03/08/2021 Record remains Non-Urgent. Unit 16 – Mormon Slough (CLM 0 to 11) is considered a patrol road/high ground area with no defined levee prism, any issue found between CLM 0 to 11 of Unit 16 will be considered a maintenance issue, or an unauthorized encroachment, or an abandoned encroachment. DWR DMP internal video inspection has found pipe integrity issues. LOF of crossing is between 5 and 6. Crossing will be monitored until funding becomes available to address the issues. Current condition of pipe crossing does not impede access to patrol road/high ground area. riar bush overgrowth limiting access and visibility on WS. Pipe appears to be deteriorating and severely corroded at the WS toe. Pipe inlet not visible on LS. Small depression visible at LS along alignment, possible location of buried pipe inlet. No permit was found authorizing this encroachment. CVFPB will need to review crossing to determine owner. The UCIP inspection was completed with LMA representative, H. Latu. (N. Cholewinski - GEI)04/30/2014 Pipe appears abandoned and if so should be done so properly. LS of pipe is buried and WS is badly rusted. Pipe should be inspected internally. (W. Wylie - DWR UCIP) FIELD_STRUCT_DESC: *High Ground* 18-inch corrugated metal drainage pipe through the levee, 3 feet below the crown. Grout over pipe in channel with pipe open and visible in water at the WS toe. [Additional Reference(s): DWR Levee Log, 1992. USACE San Joaquin O&M Manual 611.1, Volume F, (HLM 5.69)]. FS Date: 3/8/2021

LS View: Small depression visible at LS.

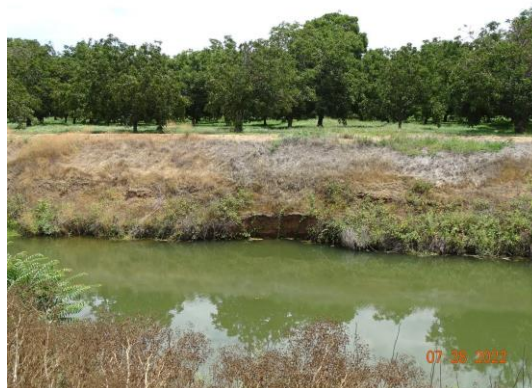
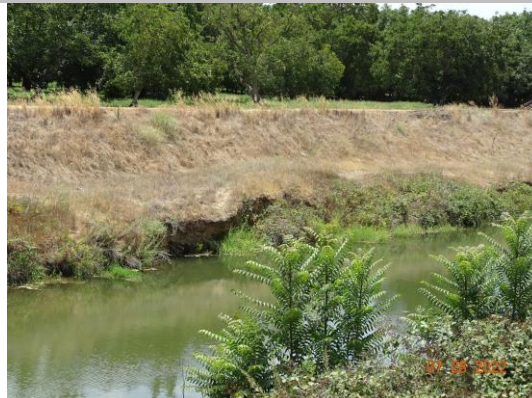
*This area is patrol road only and therefore the site is not rated
07/28/2022: From 2014 to present, no significant changes were observed during the annual survey. The erosion is visible in three locations.

09/12/2013: The erosion seems to be caused by high river flow. Dense vegetation is present at the site. Signs of animal activities are visible. There is no levee structure on site.

7/28/2022: View of the erosion from the opposite bank.

7/28/2022: Another view of the erosion.

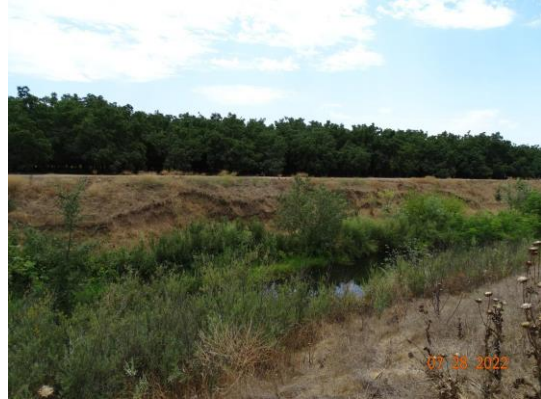
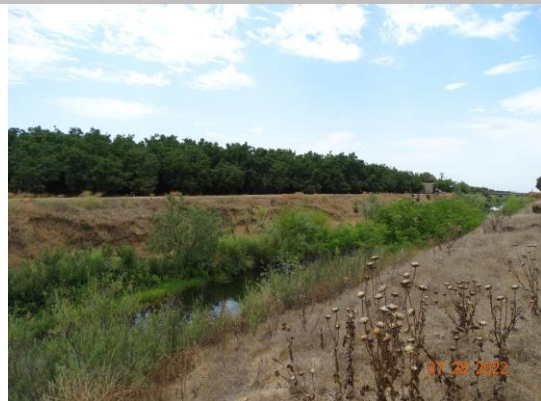
*This area is patrol road only and therefore the site is not rated
07/28/2022: From 2014 to present, no significant changes were observed during the annual survey. Noticed several locations with signs of burrowing activity near the downstream end of the erosion site. The erosion length was updated to 600 ft based on more accurate field measurements.

7/28/2022: View of the erosion from the opposite bank.

7/28/2022: Another view of the erosion.

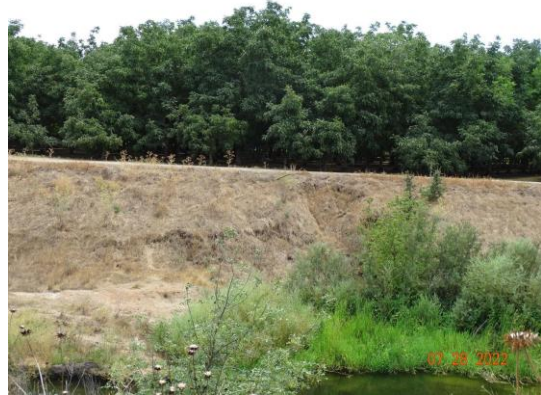
Photo 1 of 1 : SJR2022_NA0017U16RM16.15_2.JPG

LM Start	6.70	Rating **	A/W	Issue No.	39
LM End	6.71	Issue Type +	Ma	Location *	
Category	Supplemental			GPS Latitude/Longitude	
				Start	End
Item	DWR Erosion Survey			37.982299 °	37.982299 °
				-121.092665 °	-121.092665 °
DWR ID	NA0017U16RM16.15				
Comment Code					
Inspector Comment					
Site ID: NA0017U16RM16.15					
*This area is patrol road only and therefore the site is not rated					
07/28/2022: From 2020 to present, no changes were observed during the annual survey.					
08/29/2019: There is no levee at the site. The erosion is likely caused by surface runoff.

7/28/2022: View of the erosion from the opposite bank.

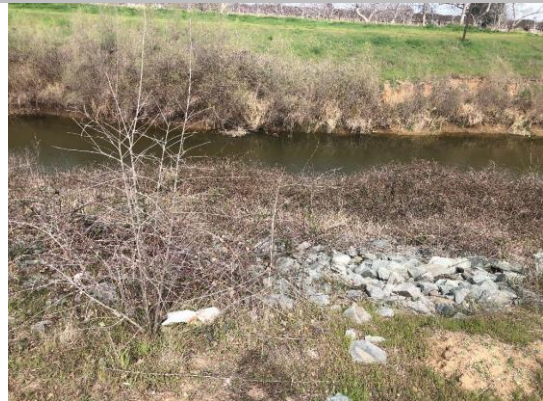
Photo 3 of 3 : UCIP_FA_2022_66042_95026.jpg

FIELD_STRUCT_DESC: 18-inch corrugated metal drainage pipe, 3-foot invert below the crown. Drain inlet ungated. [Additional Reference(s): USACE San Joaquin O&M Manual 611.1, Volume F, (HLM 7.10)].						
FS Date: 3/8/2021

WS View: Angular cobbles on WS slope.

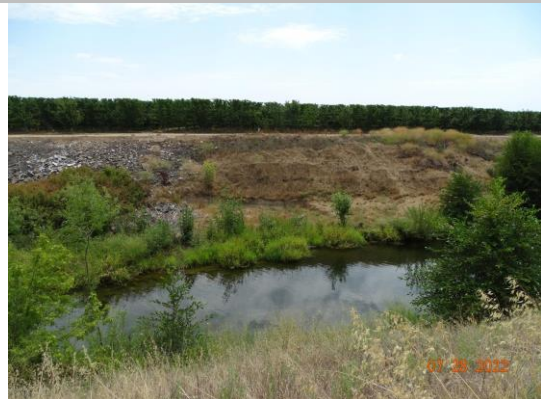
Photo 1 of 2 : SJR2022_NA0017U16RM15.57_2.JPG

*This area is patrol road only and therefore the site is not rated
07/28/2022: From 2014 to present, no significant changes were observed during the annual survey. The erosion length was updated to 80 ft based on more accurate field measurements. The site ID changed from NA0017U16RM10.82 to NA0017U16RM15.57 in 2014 to reflect the correct river mile.

09/12/2013: The site is located at immediately downstream of a levee segment protected by broken concrete. There is no levee structure on site.

7/28/2022: View of the erosion from the opposite bank.

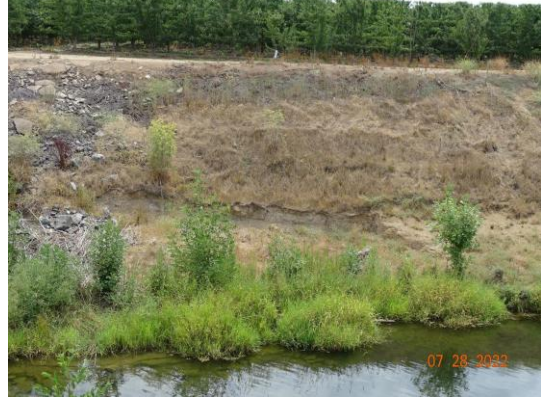
Photo 2 of 2 : SJR2022_NA0017U16RM15.57_3.JPG

7/28/2022: Close-up view of the erosion.

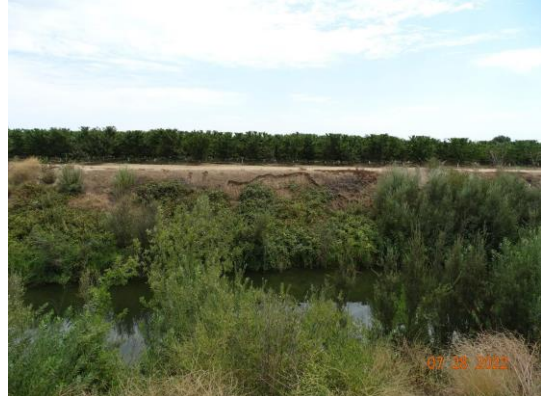
Photo 1 of 2 : SJR2022_NA0017U16RM15.45_2.JPG

*This area is patrol road only and therefore the site is not rated
07/28/2022: From 2021 to present, no significant changes were observed during the annual survey.

07/24/2020: This site was discovered during the DWR Fall 2015 Levee Inspections and first included in the erosion survey in 2019. Some fill, which is eroding, was placed on top of the erosion in one location.

7/28/2022: View of the erosion from the opposite bank.

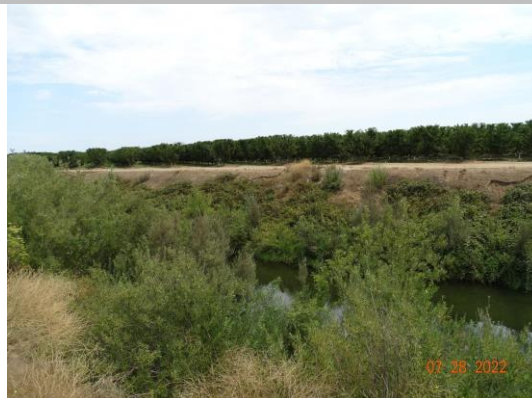
Photo 2 of 2 : SJR2022_NA0017U16RM15.45_3.JPG

7/28/2022: Another view of the erosion.

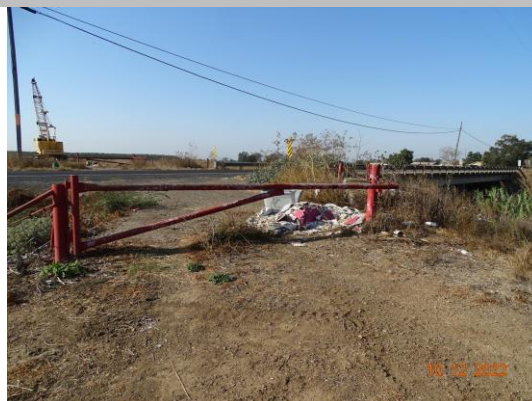
Photo 1 of 1 : FA_2022_NA0017_160_285_20221024_00630.jpg

LM Start	8.05	Rating **	M	Issue No.	285
LM End	8.05	Issue Type +	Ma	Location *	WS
Category	Earthen Levee			GPS Latitude/Longitude	
				Start	End
Item	Encroachments			37.971953 °	37.971953 °
				-121.112837 °	-121.112837 °
DWR ID	DWR_NA0017_16_f_2022_285				
Comment Code					
DE : Debris					
Inspector Comment

View of debris along the waterside shoulder. Fall 2022

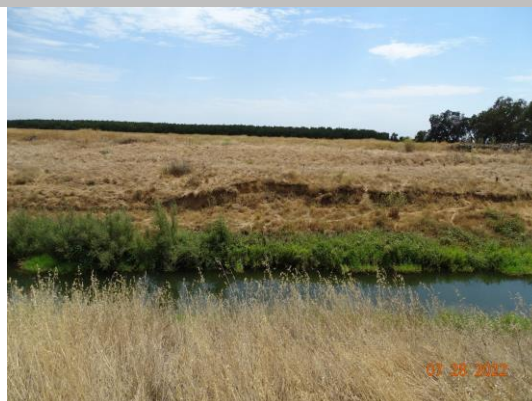
Photo 1 of 2 : SJR2022_NA0017U16RM14.48_2.JPG

LM Start	8.34	Rating **	A/W	Issue No.	29
LM End	8.38	Issue Type +	Ma	Location *	
Category	Supplemental			GPS Latitude/Longitude	
				Start	End
Item	DWR Erosion Survey			37.969213 °	37.969213 °
				-121.116574 °	-121.116574 °
DWR ID	NA0017U16RM14.48				
Comment Code					
Inspector Comment					
Site ID: NA0017U16RM14.48					
*This area is patrol road only and therefore the site is not rated					
07/28/2022: From 2013 to present, no significant changes were					
observed during the annual survey. The erosion length was updated to					
200 ft based on more accurate field measurements.					
08/22/2012: The erosion occurred on a berm of approximately 25 ft.					
wide. Site is covered with dense vegetation. There is no levee structure					
on site.

7/28/2022: View of the erosion from the opposite bank.

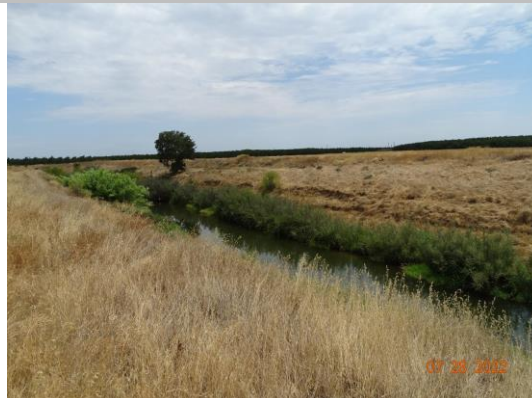
Photo 2 of 2 : SJR2022_NA0017U16RM14.48_3.JPG

7/28/2022: View of the erosion looking upstream.

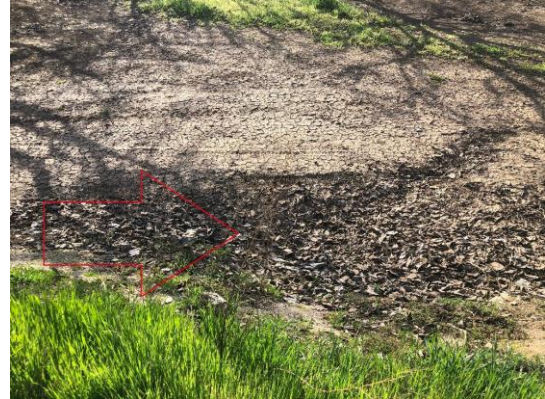
Photo 3 of 3 : UCIP_FA_2022_65870_94942.jpg

LS View: Depression at LS toe.

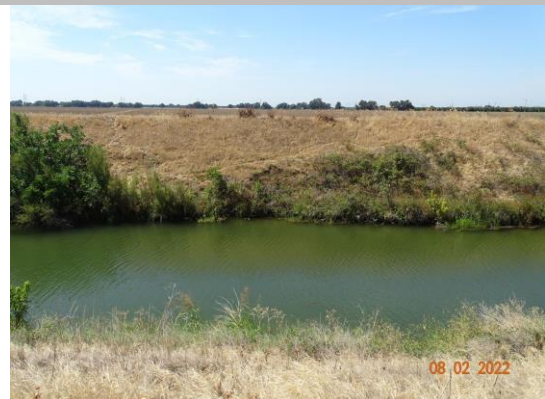
Photo 1 of 2 : SJR2022_NA0017U16RM13.85_2.JPG

*This area is patrol road only and therefore the site is not rated
08/02/2022: From 2014 to present, no significant changes were observed during the annual survey. The site was combined with NA0017U16RM13.83 and NA0017U16RM13.86 and the length increased to 160 ft.

09/12/2013: The erosion might have been caused by river flow combined with runoff. Dense vegetation is presents at the site. There is no levee structure on site.

8/2/2022: View of the erosion from the opposite bank.

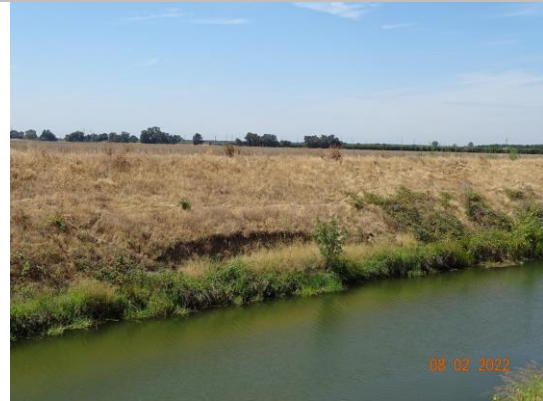
Photo 2 of 2 : SJR2022_NA0017U16RM13.86_2.JPG

8/2/2022: View of the erosion further upstream.

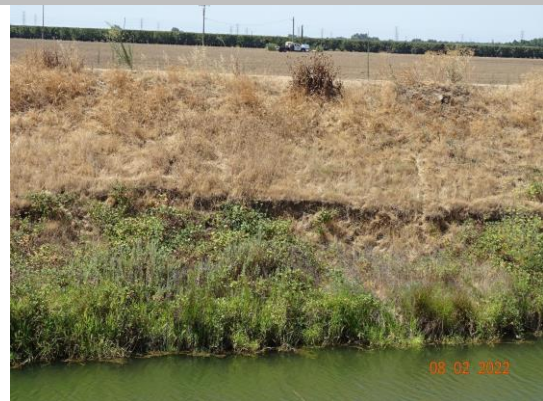
Photo 1 of 1 : SJR2022_NA0017U16RM13.72_2.JPG

*This area is patrol road only and therefore the site is not rated
08/02/2022: From 2013 to present, no significant changes were observed during the annual survey. The erosion length was updated to 110 ft based on more accurate field measurements.
08/22/2012: The erosion is covered with dense vegetation. There is no levee structure on site.

8/2/2022: View of the erosion from the opposite bank.

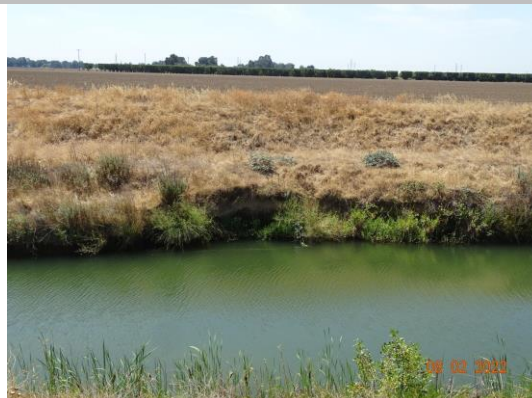
Photo 1 of 2 : SJR2022_NA0017U16RM13.53_3.JPG

LM Start	9.31	Rating **	A/W	Issue No.	31
LM End	9.33	Issue Type +	Ma	Location *	
Category	Supplemental			GPS Latitude/Longitude	
				Start	End
Item	DWR Erosion Survey			37.966772 °	37.966772 °
				-121.133071 °	-121.133071 °
DWR ID	NA0017U16RM13.53				
Comment Code					
Inspector Comment					
Site ID: NA0017U16RM13.53					
*This area is patrol road only and therefore the site is not rated					
08/02/2022: From 2013 to present, no significant changes were					
observed during the annual survey. The erosion length was updated to					
130 ft based on more accurate field measurements.					
08/22/2012: The erosion is on berm. The berm width is estimated.					
There is no levee structure on site.

8/2/2022: View of the erosion from the opposite bank.

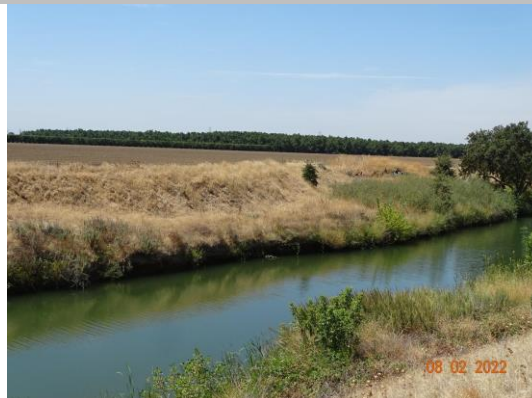
Photo 2 of 2 : SJR2022_NA0017U16RM13.53_4.JPG

8/2/2022: View of the erosion a little further downstream.

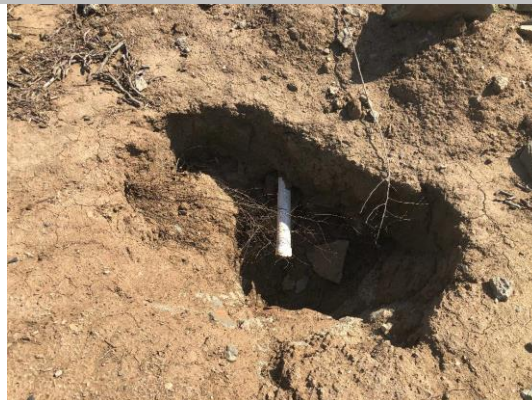
Photo 2 of 3 : UCIP_FA_2022_65879_94890.jpg

LS View: PVC pipe discharging at LS pipe opening.

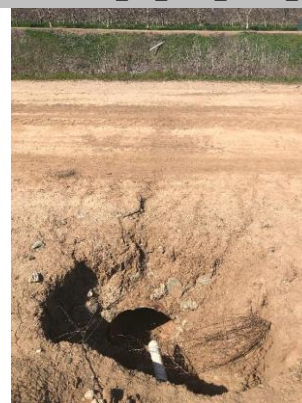
Photo 3 of 3 : UCIP_FA_2022_65879_94891.jpg

LS View: PVC pipe discharging at LS pipe opening.

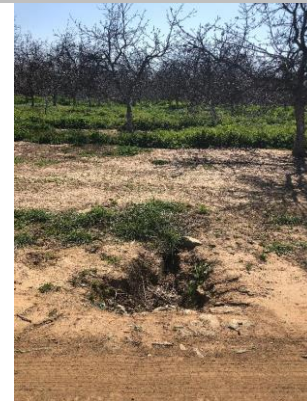
Photo 2 of 3 : UCIP_FA_2022_65881_94883.jpg

LS View: Pipe damaged at LS.

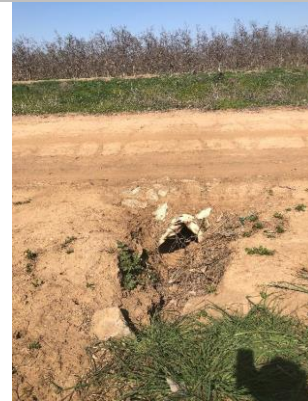
Photo 3 of 3 : UCIP_FA_2022_65881_94884.jpg

LS View: Pipe damaged at LS.

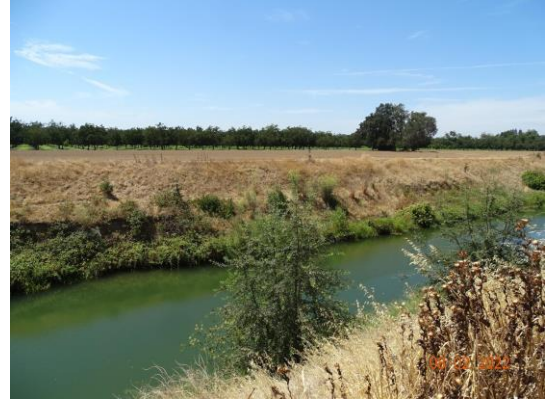
Photo 2 of 2 : SJR2022_NA0017U16RM12.95_4.JPG

*This area is patrol road only and therefore the site is not rated
08/02/2022: From 2013 to present, no significant changes were observed during the annual survey. The erosion length was updated to 80 ft based on more accurate field measurements.
08/22/2012: Dense vegetation on site. There is no levee structure on site.

8/2/2022: Another view of the erosion.

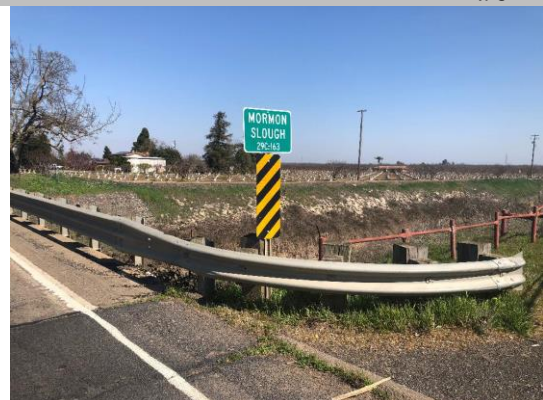
Photo 2 of 3 : UCIP_FA_2022_65884_94864.jpg

WS View

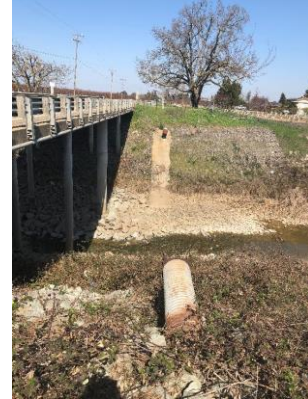
Photo 3 of 3 : UCIP_FA_2022_65884_94865.jpg

WS View: Pipe and flapgate at WS slope. Briar bush overgrowth present.

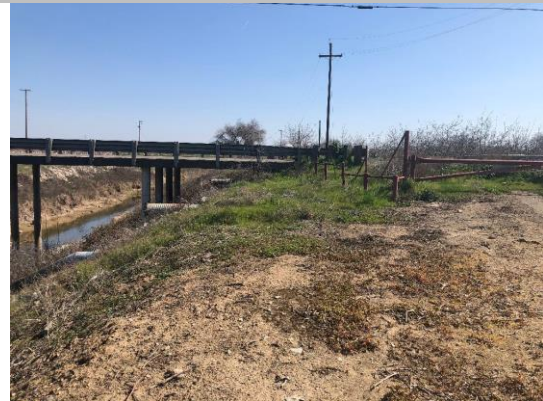
Photo 1 of 3 : UCIP_FA_2022_65887_94853.jpg

Crossing Overview

Comment Code					
Inspector Comment					
DS_ID:23348 FS_ID:65887 EP_NO: N/A Repair Type: Non-Urgent EVAL Issue: 11, Maintenance Compliance Issue Crossing Status: Found UCIP Comments: 03/04/2021 Record was updated from No Action Needed to Non-Urgent. Unit 16 – Mormon Slough (CLM 0 to 11) is considered a patrol road/high ground area with no defined levee prism, any issue found between CLM 0 to 11 of Unit 16 will be considered a maintenance issue, or an unauthorized encroachment, or an abandoned encroachment. DWR DMP has found integrity issues, LOF between 5 and 6. Crossing will be monitored until funding becomes available for rehabilitation. Current condition of pipe crossing does not impede access to patrol road/high ground area. No permit was found authorizing this encroachment. CVFPB will need to review crossing to determine owner. The UCIP inspection was completed with LMA representative, H. Latu. (N. Cholewinski - GEI) FIELD_STRUCT_DESC: "High Ground" 18-inch corrugated metal drainage pipe through the levee, 6 feet below the crown. Concrete headwall on the landside (LS). Flap gate on the waterside (WS). [Additional Reference(s): DWR Levee Log, 1992. USACE San Joaquin O&M Manual 611.1, Volume F, (HLM 10.51)]. FS Date: 3/4/2021

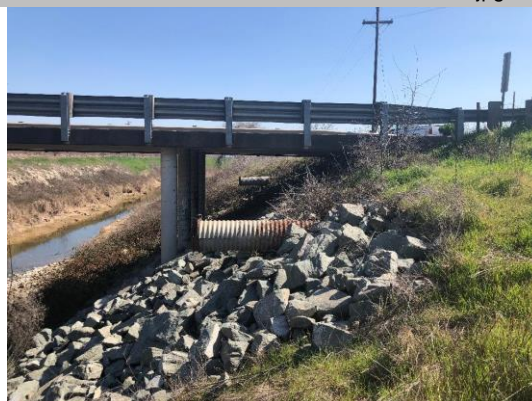
Photo 2 of 3 : UCIP_FA_2022_65887_94854.jpg

WS View: Pipe and flapgate at WS slope.

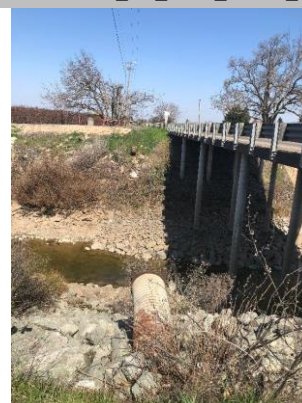
Photo 3 of 3 : UCIP_FA_2022_65887_94855.jpg

WS View: Pipe and flapgate at WS slope.

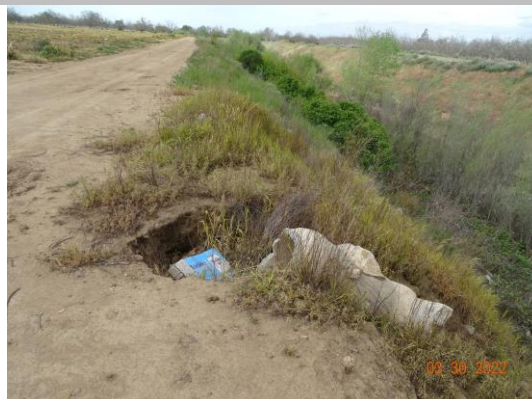
Photo 1 of 1 : FA_2022_NA0017_160_288_20220919_00088.jpg

LM Start	10.57	Rating **	M	Issue No.	288
LM End	10.57	Issue Type +	Ma	Location *	WS
Category	Earthen Levee			GPS Latitude/Longitude	
				Start	End
Item	Erosion / Bank Caving			37.963542 °	37.963542 °
				-121.155111 °	-121.155111 °
DWR ID	DWR_NA0017_16_f_2019_288				
Comment Code					
E2 : Schedule repair of erosion site prior to the next inspection.					
Inspector Comment					
Erosion may cut into patrol access road.

View of erosion on the waterside shoulder. Spring 2022

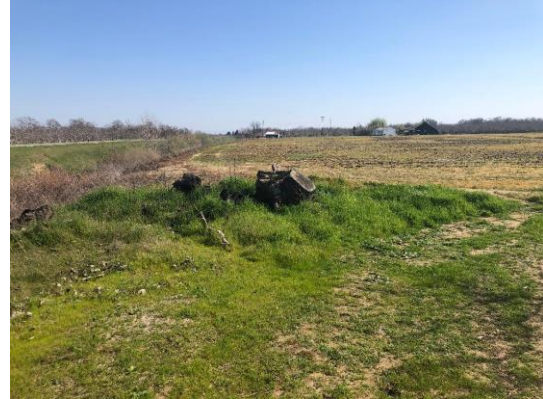
Photo 1 of 3 : UCIP_FA_2022_66083_94830.jpg

Comment Code						
Inspector Comment						
DS_ID:23351 FS_ID:66083 EP_NO: N/A Repair Type: Non-Urgent EVAL Issue: Crossing Status: Indicator Found UCIP Comments: 03/04/2021 Record remains Non-Urgent. Unit 16 – Mormon Slough (CLM 0 to 11) is considered a patrol road/high ground area with no defined levee prism, any issue found between CLM 0 to 11 of Unit 16 will be considered a maintenance issue, or an unauthorized encroachment, or an abandoned encroachment. Current condition of pipe crossing does not impede access to patrol road/high ground area. No permit has been identified authorizing utility. CVFPB will need to review crossing to determine owner. Pipe not visible at grout apron on WS. No pipe inlet visible on LS. The UCIP inspection was completed with LMA representative, H. Latu. (N. Cholewinski - GEI)05/06/2014 Inlet appears to be buried on LS toe. (W. Wylie - DWR UCIP) FIELD_STRUCT_DESC: 18-inch corrugated metal drainage pipe, 3.5 feet below the roadway. Grout over pipe in spillway. [Additional Reference(s): DWR Levee Log, 1992. USACE San Joaquin O&M Manual 611.1, Volume F, (HLM 11.05)]. FS Date: 3/4/2021

Crossing Overview

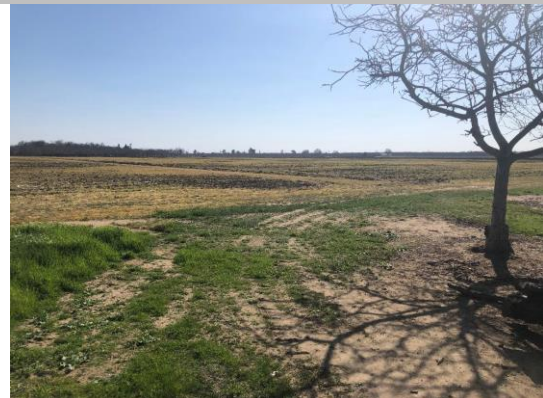
Photo 2 of 3 : UCIP_FA_2022_66083_94831.jpg

LS View

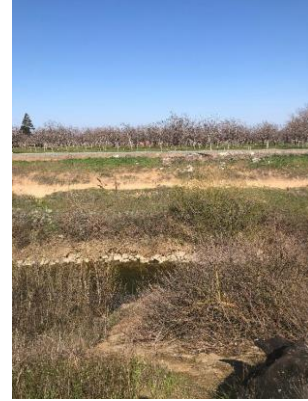
Photo 3 of 3 : UCIP_FA_2022_66083_94832.jpg

WS View: Grout apron at WS slope.
