**Flood Control Project Maintenance
Levee Inspections**

Maintenance Issue Types Only, Levee Inspection Report By Mile - Fall 2022

San Joaquin County Flood Control and Water Conservation District

Waterway	Bank	Unit Miles	Inspection Start/End	Inspector
Unit No. 01 Littlejohn Creek	Left	2.59	10/13/2022 10/13/2022	Alberto De Leon

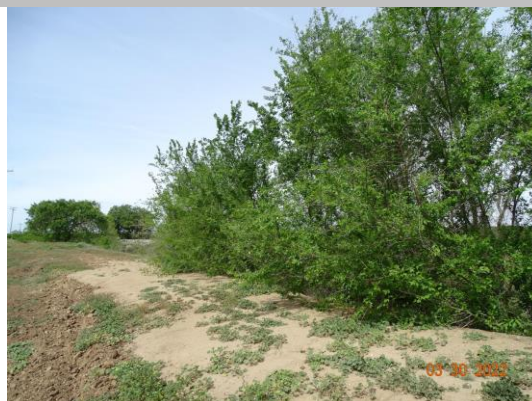
Photo 1 of 1 : FA_2022_NA0017_160_3_20220919_00002.jpg

LM Start	10.90	Rating **	U	Issue No.	3
LM End	10.90	Issue Type +	Ma	Location *	CR
Category	Earthen Levee			GPS Latitude/Longitude	
				Start	End
Item	Trim / Thin Trees			37.961464 °	37.961464 °
				-121.160376 °	-121.160376 °
DWR ID	DWR_NA0017_16_s_2022_3				
Comment Code					
T4 : Trim trees over roadway to at least 12 feet above ground level.					
Inspector Comment

View of untrimmed trees along the waterside of the crown. Spring 2022

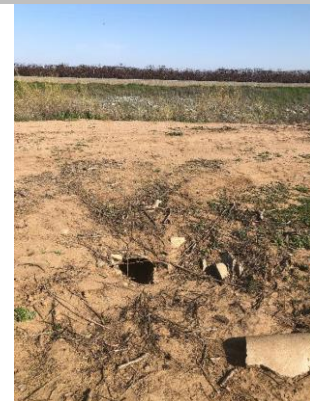
Photo 2 of 3 : UCIP_FA_2022_63857_94806.jpg

LS View: Soil accumulation and concrete debris at pipe opening.

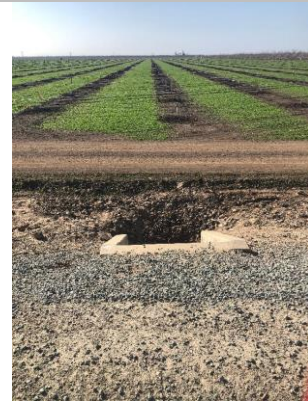
Photo 2 of 3 : UCIP_FA_2022_65153_94796.jpg

LS View: Headwall at LS toe.

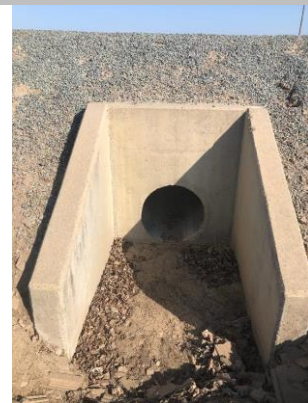
Photo 3 of 3 : UCIP_FA_2022_65153_94797.jpg

LS View: Headwall at LS toe.

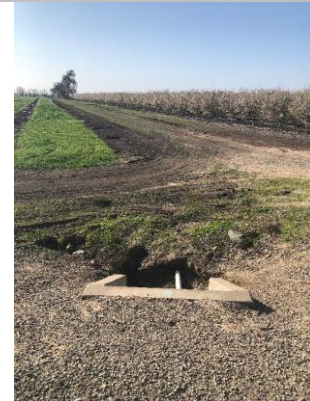
Photo 2 of 3 : UCIP_FA_2022_63851_94768.jpg

LS View: Headwall at LS toe.

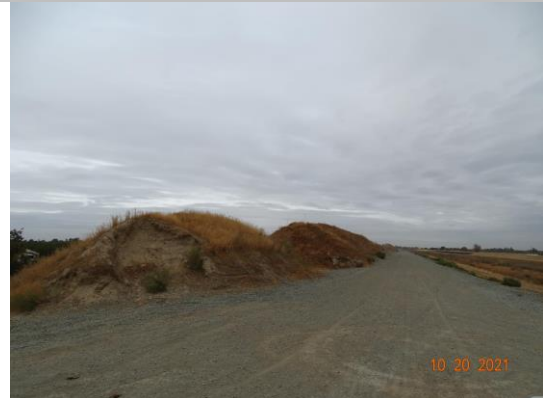
Photo 1 of 1 : FA_2022_NA0017_160_277_20220919_00084.jpg

LM Start	13.56	Rating **	U	Issue No.	277
LM End	14.01	Issue Type +	Ma	Location *	CR
Category	Earthen Levee			GPS Latitude/Longitude	
				Start	End
Item	Encroachments			37.961604 °	37.965214 °
				-121.206605 °	-121.213627 °
DWR ID	DWR_NA0017_16_s_2019_277				
Comment Code					
MA : Material					
Inspector Comment					
Fill material stored on landside crown.

View of fill material stored landside shoulder. Fall 2021

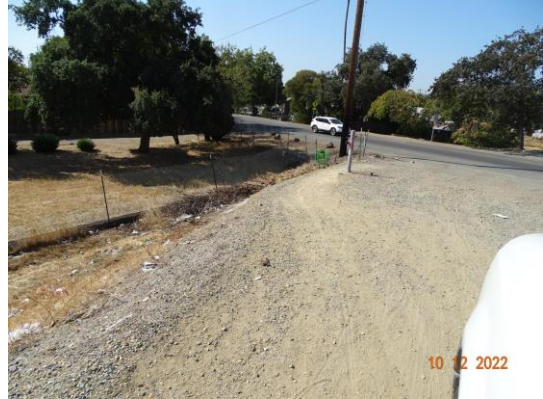
Photo 1 of 1 : FA_2022_NA0017_160_270_20221024_00632.jpg

LM Start	16.84	Rating **	A/W	Issue No.	270
LM End	16.84	Issue Type +	Ma	Location *	LS
Category	Earthen Levee			GPS Latitude/Longitude	
				Start	End
Item	Erosion / Foot Traffic			37.985132 °	37.985132 °
				-121.258825 °	-121.258825 °
DWR ID	DWR_NA0017_16_s_2021_270				
Comment Code					
E3 : Repair the levee slope damaged by foot traffic and prevent access where possible.					
Inspector Comment

View of pedestrian pathway along the landside slope. Fall 2022

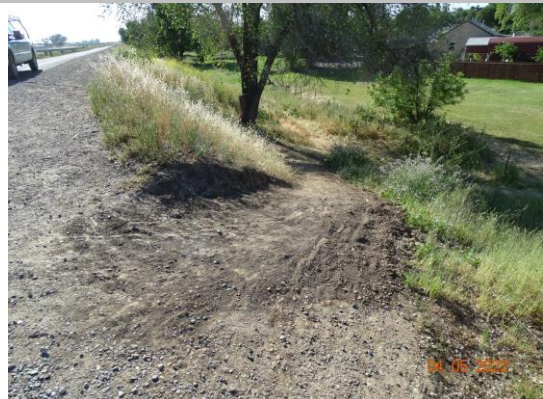
Photo 1 of 1 : FA_2022_NA0017_160_289_20220919_00089.jpg

LM Start	17.07	Rating **	M	Issue No.	289	
LM End	17.07	Issue Type +	Ma	Location *	LS	
Category	Earthen Levee			GPS Latitude/Longitude		
				Start		End
Item	Erosion / Foot Traffic			37.986713 °		37.986713 °
				-121.262346 °		-121.262346 °
DWR ID	DWR_NA0017_16_s_2022_289					
Comment Code						
E3 : Repair the levee slope damaged by foot traffic and prevent access where possible.						
Inspector Comment

View of foot path along the landside slope. Spring 2022

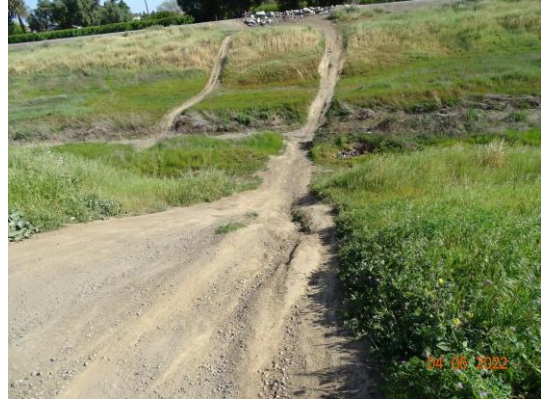
Photo 1 of 1 : FA_2022_NA0017_160_306_20220919_00095.jpg

LM Start	17.89	Rating **	M	Issue No.	306
LM End	17.89	Issue Type +	Ma	Location *	LS
Category	Earthen Levee			GPS Latitude/Longitude	
				Start	End
Item	Erosion / Vehicle Traffic			37.992320 °	37.992320 °
				-121.275567 °	-121.275567 °
DWR ID	DWR_NA0017_16_s_2022_306				
Comment Code					
E6 : Repair the levee slope damaged by vehicle traffic and prevent access where possible.					
Inspector Comment					
Erosion caused by off-road motorcycle activity.

View of erosion within the waterside slope caused by motorcycle traffic.
Spring 2022

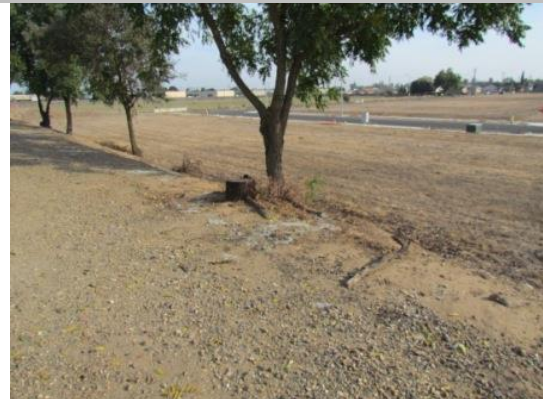
Photo 1 of 1 : FA_2022_NA0017_160_65_20220919_00060.jpg

LM Start	18.94	Rating **	N	Issue No.	65
LM End	18.94	Issue Type +	Ma	Location *	LS
Category	Earthen Levee			GPS Latitude/Longitude	
				Start	End
Item	Trim / Thin Trees			37.991937 °	37.991937 °
				-121.293932 °	-121.293932 °
DWR ID	DWR_NA0017_16_s_2012_65				
Comment Code					
T5 : Tree stumps.					
Inspector Comment

A tree stump was found on the landside of the levee looking upstream.

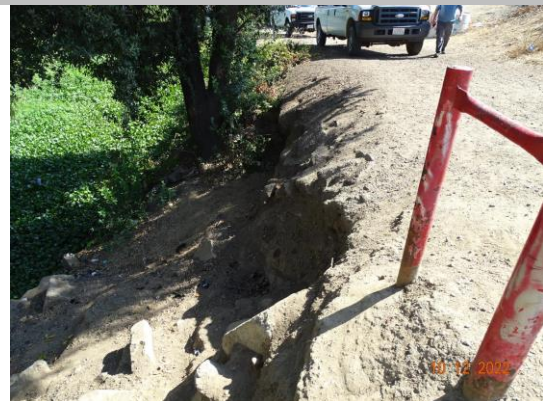
Photo 1 of 1 : FA_2022_NA0017_160_316_20221024_00636.jpg

LM Start	20.73	Rating **	U	Issue No.	316
LM End	20.73	Issue Type +	Ma	Location *	WS
Category	Earthen Levee			GPS Latitude/Longitude	
				Start	End
Item	Erosion / Bank Caving			37.979119 °	37.979119 °
				-121.319013 °	-121.319013 °
DWR ID	DWR_NA0017_16_s_2022_316				
Comment Code					
E2 : Schedule repair of erosion site prior to the next inspection.					
Inspector Comment

View of erosion/digging within the waterside slope caused by campers.
Fall 2022

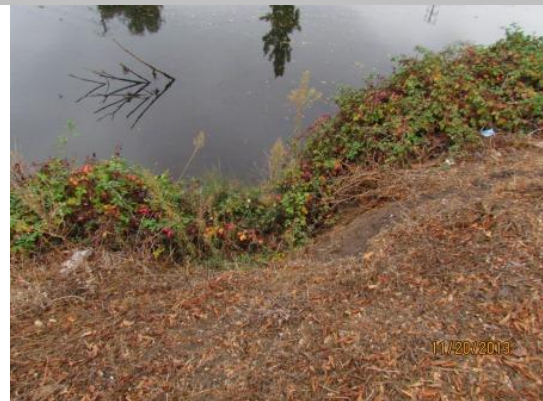
Photo 1 of 1 : FA_2022_NA0017_160_62_20220919_00058.jpg

LM Start	21.94	Rating **	A/W	Issue No.	62
LM End	21.94	Issue Type +	Ma	Location *	WS
Category	Earthen Levee			GPS Latitude/Longitude	
				Start	End
Item	Erosion / Bank Caving			37.979251 °	37.979251 °
				-121.340012 °	-121.340012 °
DWR ID	DWR_NA0017_16_f_2020_62				
Comment Code					
E1 : Note and monitor erosion site.					
Inspector Comment

Erosion was found on the waterside slope of the levee looking upstream.

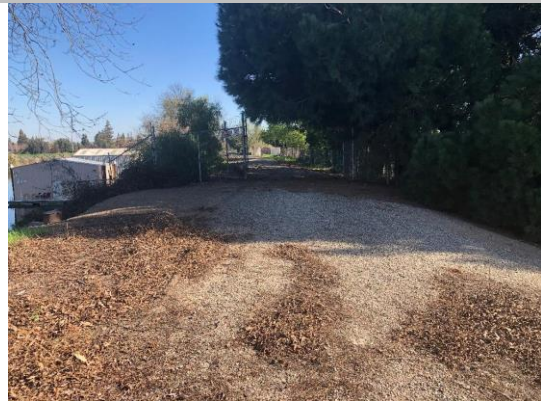
Photo 1 of 3 : UCIP_FA_2022_63488_93598.jpg

Comment Code					
Inspector Comment					
DS_ID:23407 FS_ID:63488 EP_NO: N/A Repair Type: Non-Urgent EVAL Issue: Crossing Status: Not Found UCIP Comments: 03/01/2021 Record was updated from No Action Needed to Non-Urgent. No permit was found authorizing this encroachment. CVFPB will need to review crossing to determine owner. Utility not found/ observed in the field. The UCIP inspection was completed with LMA representative, H. Latu. (N. Cholewinski - GEI) FIELD_STRUCT_DESC: 18-inch steel drainage pipe through the levee, 5.1 feet below the crown. Siphon breaker on the waterside (WS) slope. Pump house on the landside (LS). [Additional Reference(s): DWR Levee Log, 1992. USACE San Joaquin O&M Manual 611.1, Volume F, (HLM 22.88)]. FS Date: 3/1/2021

Crown Overview

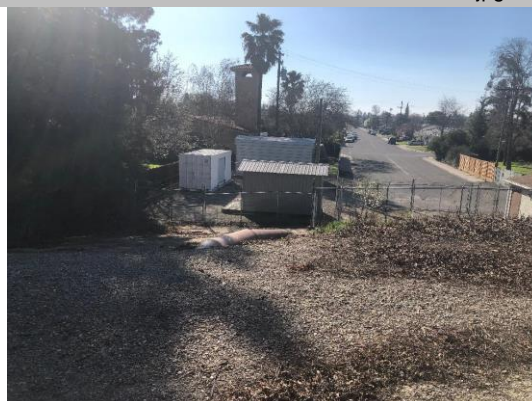
Photo 2 of 3 : UCIP_FA_2022_63488_93599.jpg

LS View

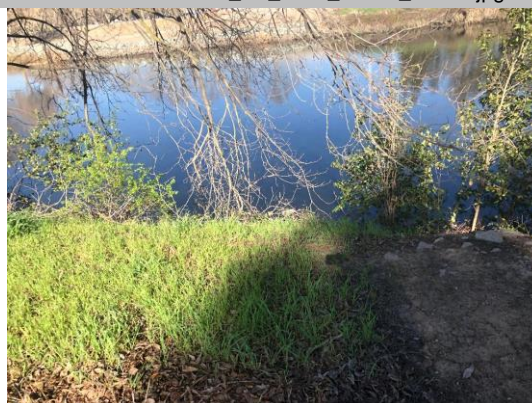
Photo 3 of 3 : UCIP_FA_2022_63488_93600.jpg

WS View

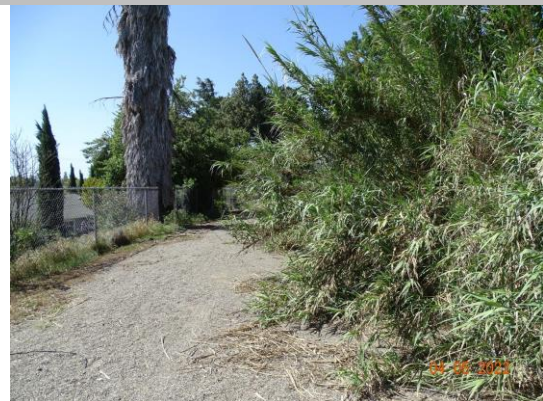
Photo 1 of 1 : FA_2022_NA0017_160_321_20220919_00097.jpg

LM Start	22.53	Rating **	U	Issue No.	321
LM End	22.54	Issue Type +	Ma	Location *	WS
Category	Earthen Levee			GPS Latitude/Longitude	
				Start	End
Item	Vegetation			37.973598 °	37.973524 °
				-121.347830 °	-121.347958 °
DWR ID	DWR_NA0017_16_s_2022_321				
Comment Code					
V2 : Remove the wild growth and woody vegetation other than native grasses from the levee slopes.					
Inspector Comment

View of Arundo within the waterside slope. Spring 2022

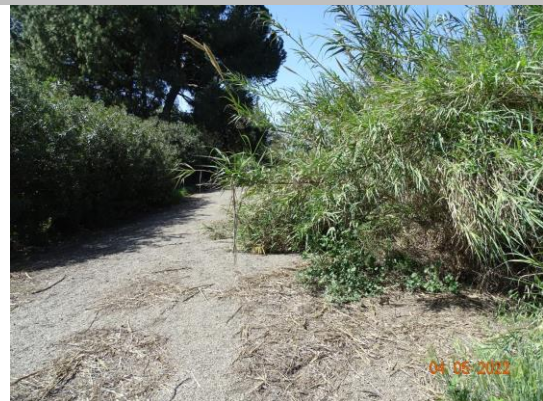
Photo 1 of 1 : FA_2022_NA0017_160_322_20220919_00098.jpg

LM Start	22.56	Rating **	U	Issue No.	322
LM End	22.56	Issue Type +	Ma	Location *	WS
Category	Earthen Levee			GPS Latitude/Longitude	
				Start	End
Item	Vegetation			37.973388 °	37.973388 °
				-121.348259 °	-121.348259 °
DWR ID	DWR_NA0017_16_s_2022_322				
Comment Code					
V2 : Remove the wild growth and woody vegetation other than native grasses from the levee slopes.					
Inspector Comment

View of Arundo within the waterside slope. Spring 2022

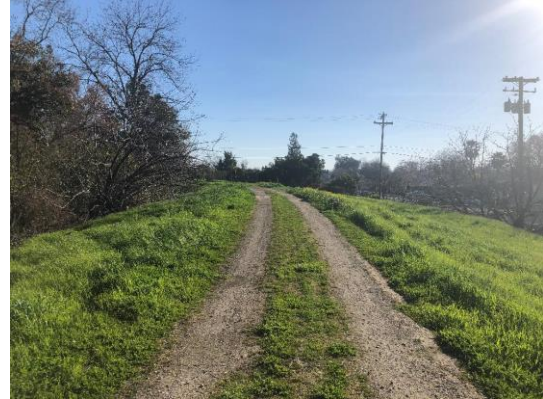
Photo 1 of 3 : UCIP_FA_2022_63483_93577.jpg

Comment Code					
Inspector Comment					
DS_ID:23409 FS_ID:63483 EP_NO: N/A Repair Type: Non-Urgent EVAL Issue: Crossing Status: Found UCIP Comments: 03/01/2021 Record was updated from No Action Needed to Non-Urgent. No permit was found authorizing this encroachment. CVFPB will need to review crossing to determine owner. No issues observed during inspection. The UCIP inspection was completed with LMA representative, H. Latu. (N. Cholewinski - GEI) FIELD_STRUCT_DESC: 1 of 2: 18-inch steel drainage pipe through the levee, 4.3 feet below the crown. Siphon breaker on the waterside (WS) slope. Pump house near the landside (LS) toe. (Reclamation District No. 1618). [Additional Reference(s): DWR Levee Log, 1992. USACE San Joaquin O&M Manual 611.1, Volume F, (HLM 23.36)]. FS Date: 3/1/2021

Crown Overview

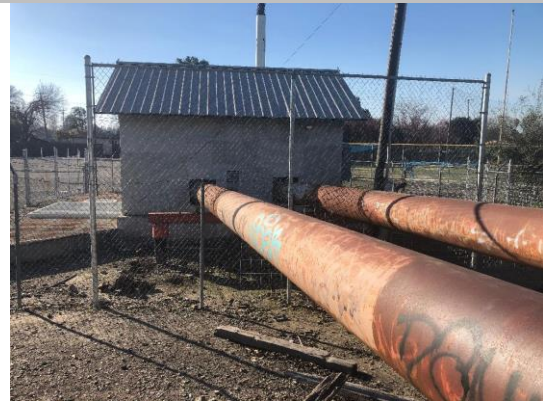
Photo 2 of 3 : UCIP_FA_2022_63483_93578.jpg

LS View: Pipe and pumphouse at LS toe.

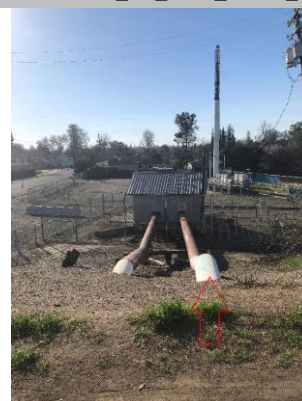
Photo 3 of 3 : UCIP_FA_2022_63482_93575.jpg

LS View: Pipe and pumphouse at LS slope and toe.

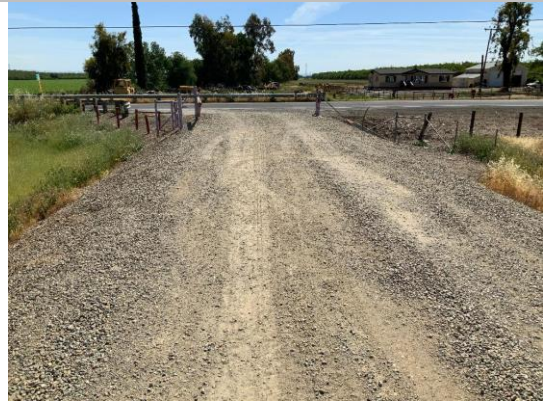
Photo 1 of 2 : UCIP_FA_2022_66204_98503.jpg

Comment Code						
Inspector Comment						
DS_ID:18542 FS_ID:66204 EP_NO: N/A Repair Type: Non-Urgent EVAL Issue: Crossing Status: Not Found UCIP Comments: 04/29/2021 The record has been upgraded from No Action Needed to Non-Urgent. Pipe not found by visual inspection. This appears to be a double of DSID 23592 as the specifications are identical, needs confirmation. No permit was found authorizing this encroachment. CVFPB will need to review crossing to determine owner. The UCIP inspection was completed with LMA representative, J. Nelson. (H. Dunn – GEI) FIELD_STRUCT_DESC: 30-inch corrugated metal drainage pipe through the levee, 6 feet below the crown. Concrete U-shaped headwalls on both ends. Flap gate on the waterside (WS) end. Grouted intake and outlet. [Additional Reference(s): DWR Levee Log, 1992, 36-inch pipe listed. USACE San Joaquin O&M Manual 611.1, Volume F, (HLM 0.00)]. FS Date: 4/29/2021

Levee crown looking upstream.

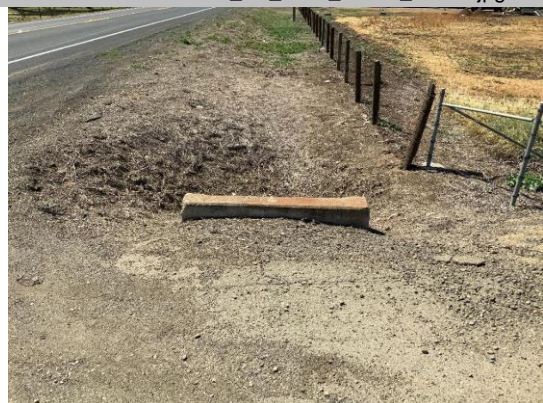
Photo 2 of 2 : UCIP_FA_2022_66204_98504.jpg

LS view: Toe from crown, pipe not visible.

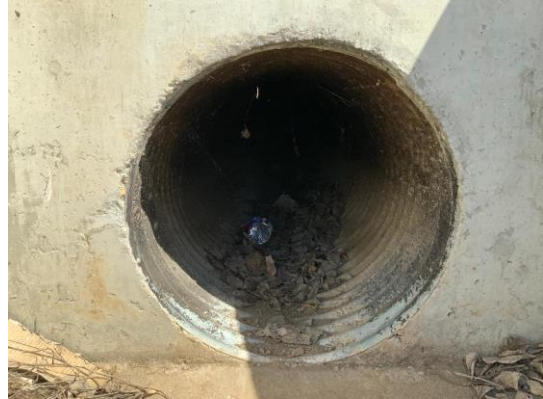
Photo 3 of 3 : UCIP_FA_2022_67115_98741.jpg

LS view: Close up of pipe inlet.

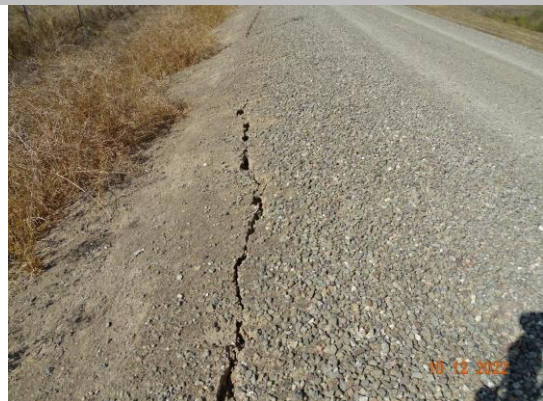
Photo 1 of 1 : FA_2022_NA0017_162_11_20221024_00024.jpg

LM Start	0.08	Rating **	M	Issue No.	11
LM End	0.08	Issue Type +	Ma	Location *	LS
Category	Earthen Levee			GPS Latitude/Longitude	
				Start	End
Item	Slope Stability			37.957513 °	37.957513 °
				-121.149988 °	-121.149988 °
DWR ID	DWR_NA0017_18_f_2022_11				
Comment Code					
S1 : Repair slope instability.					
Inspector Comment					
There is a 40 foot crack approximately 2 inches wide by 4 inches deep along the landside slope.

View of soil separation along the landside slope. Fall 2022

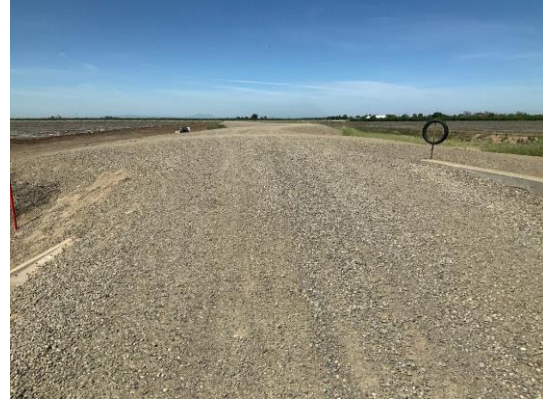
Photo 1 of 3 : UCIP_FA_2022_67111_98748.jpg

Comment Code					
Inspector Comment					
DS_ID:18541 FS_ID:67111 EP_NO: N/A Repair Type: Urgent EVAL Issue: 3a, Flood Risk Crossing Status: Found UCIP Comments: 04/29/2021 The record has been upgraded from No Action Needed to Urgent. There is a new plastic irrigation pipe going through this metal pipe that prevents the flapgate from closing. Pipe needs to be removed before flood season so flapgate can close. No permit was found authorizing this encroachment. CVFPB will need to review crossing to determine owner. The UCIP inspection was completed with LMA representative, J. Nelson. (H. Dunn – GEI) 04/04/2014 Long flood wall along the levee. (P. Mahesh - DWR UCIP) FIELD_STRUCT_DESC: 30-inch corrugated metal drainage pipe through the levee, 6 feet below the crown. Concrete U-shaped headwall on both ends. Flap gate on the waterside (WS) end. Grouted inlet and outlet. [Additional Reference(s): DWR Levee Log, 1992, 36-inch pipe listed. USACE San Joaquin O&M Manual 611.1, Volume F, (HLM 0.28)]. FS Date: 4/29/2021

Levee crown looking downstream.

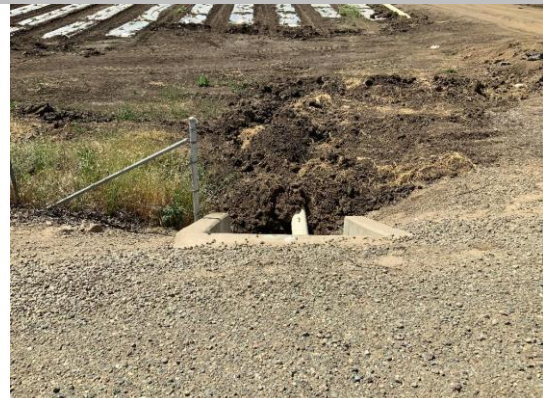
Photo 2 of 3 : UCIP_FA_2022_67111_98750.jpg

LS view: Headwall visible at toe from crown.

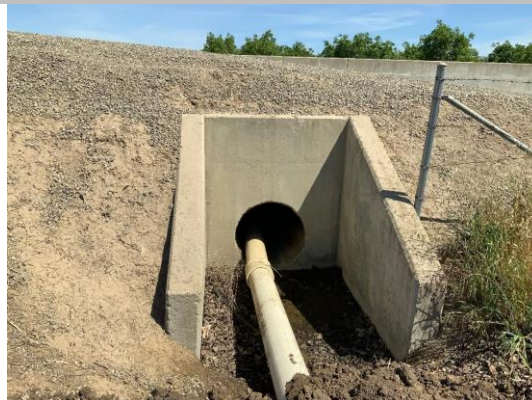
Photo 3 of 3 : UCIP_FA_2022_67111_98751.jpg

LS view: Slope and headwall at toe. Irrigation pipe going through inlet.

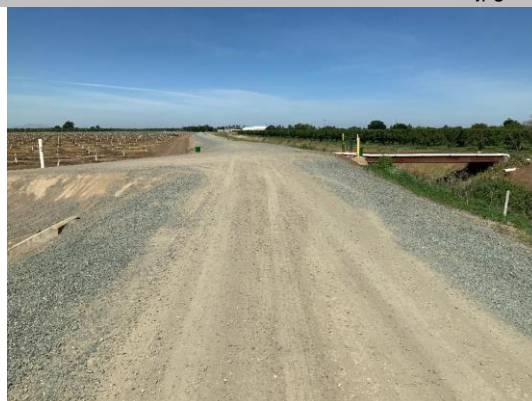
Photo 1 of 3 : UCIP_FA_2022_66338_98760.jpg

LM Start	0.53	Rating **	M	Issue No.	15	
LM End	0.53	Issue Type +	Ma	Location *		
Category	Supplemental			GPS Latitude/Longitude		
				Start		End
Item	DWR UCIP LMA Responsibility			37.959096 °		37.959096 °
				-121.157536 °		-121.157536 °
DWR ID	23954					
Comment Code						
Inspector Comment						
DS_ID:23954 FS_ID:66338 EP_NO: N/A Repair Type: Non-Urgent EVAL Issue: Crossing Status: Not Found UCIP Comments: 04/29/2021 The record has been upgraded from No Action Needed to Non-Urgent. Pipe not found by visual inspection. No permit was found authorizing this encroachment. CVFPB will need to review crossing to determine owner. The UCIP inspection was completed with LMA representative, J. Nelson. (H. Dunn – GEI) FIELD_STRUCT_DESC: 30-inch pipe through the levee; concrete headwalls on both sides of the levee. O&M manual SJR 611.1 Vol. F-revised in 2010. FS Date: 4/29/2021

Levee crown looking downstream.

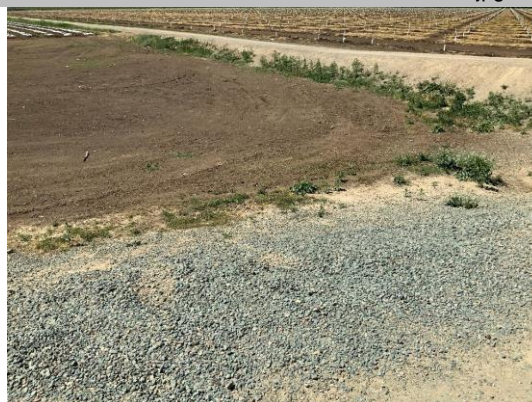
Photo 2 of 3 : UCIP_FA_2022_66338_98761.jpg

LS view: Toe from crown, no pipe visible.

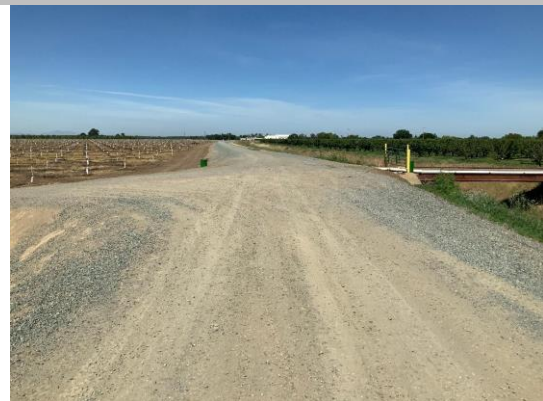
Photo 1 of 3 : UCIP_FA_2022_67112_98763.jpg

DS_ID:18539
 FS_ID:67112
 EP_NO: N/A
 Repair Type: Urgent
 EVAL Issue: 1, Pipe Integrity
 Crossing Status: Found
 UCIP Comments: 04/29/2021 Record has been upgraded from No Action Needed to Urgent. DWR DMP internal video inspection has found pipe integrity issues. LOF of crossing is between 5 and 6. Crossing will be monitored until funding becomes available to address the issues. No permit was found authorizing this encroachment. CVFPB will need to review crossing to determine owner. The UCIP inspection was completed with LMA representative, J. Nelson. (H. Dunn – GEI)04/04/2014 May need cleaning the pipe. (P. Mahesh - DWR UCIP)
 FIELD_STRUCT_DESC: 30-inch corrugated metal drainage pipe through the levee, 6 feet below the crown. Concrete U-shaped headwalls on both ends. Flap gate on the waterside (WS) end. Grouted inlet and outlet. [Additional Reference(s): DWR Levee Log, 1992, 36-inch pipe listed. USACE San Joaquin O&M Manual 611.1, Volume F, (HLM 0.54)].

Levee crown looking downstream.
