**Flood Control Project Maintenance
Levee Inspections**

Maintenance Issue Types Only, Levee Inspection Report By Mile - Fall 2023

San Joaquin County Flood Control and Water Conservation District

Waterway	Bank	Unit Miles	Inspection Start/End	Inspector
Unit No. 01 Littlejohn Creek	Left	2.59	10/20/2023 10/20/2023	Alberto De Leon

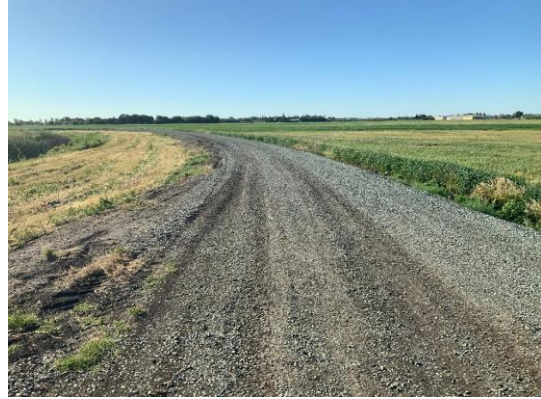
Photo 1 of 3 : UCIP_FA_2023_80420_96772.jpg

Comment Code					
Inspector Comment					
DS_ID:17965 FS_ID:80420 EP_NO: N/A Repair Type: Non-Urgent EVAL Issue: 5, Pipe Damage Crossing Status: Found UCIP Comments: 06/21/2023 Pipe diameter was DMP field confirmed to be 15 inches. (O.Yakimov - DWR UCIP) 03/31/2023 Record updated from Urgent to Non-Urgent. LoF is equal to 5 due to pipe deformation, integrity issues are not found. Crossing will be monitored until funding becomes available for rehabilitation. (O.Yakimov - DWR UCIP) 04/27/2021 Record has been upgraded from Non-Urgent to Urgent. DWR DMP internal video inspection has found pipe integrity issues. LOF of crossing is between 5 and 6. Crossing will be monitored until funding becomes available to address the issues. LS pipe edges are still slightly warped, but have been reshaped greatly since last report. Levee prism in this section appears to be less than 3 feet. No permit was found authorizing this encroachment. CVFPB will need to review crossing to determine owner. The UCIP inspection was completed with LMA representative, J. Nelson. (H. Dunn ? GEI) 03/25/2014 May need cleaning of the pipe. Reshaping the pipe end on landside. (P. Tariq - DWR UCIP) FIELD_STRUCT_DESC: 15-inch corrugated metal drainage pipe (CMP) through the levee, 6.0 feet below the crown. Flap gate on the waterside (WS) end. Inlet open on the landside (LS). [Additional Reference(s): DWR Levee Log, 1977, (HLM 0.43), 24-inch pipe listed. USACE San Joaquin O&M Manual, Unit No. 613, Part C, May 1963, Revised 15 April 2010, (Station 131+25 "S"), 24-inch pipe listed. USACE As-Built File No. CA-2-6-147, Sheet No. 147/2, 25 March 1954, (Station 131+25 "S"), 24-inch pipe listed]. FS Date: 4/27/2021

Levee crown looking downstream.

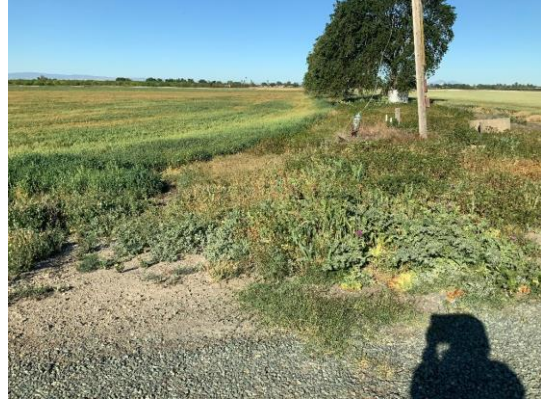
Photo 2 of 3 : UCIP_FA_2023_80420_96767.jpg

LM Start	0.17	Rating **	M	Issue No.	36 (cont)
LM End	0.17	Issue Type +	Ma	Location *	
Category	Supplemental			GPS Latitude/Longitude	
				Start	End
Item	DWR UCIP LMA Responsibility			37.873926°	37.873926°
				-121.233588°	-121.233588°
DWR ID	17965

LS view: Slope from crown.

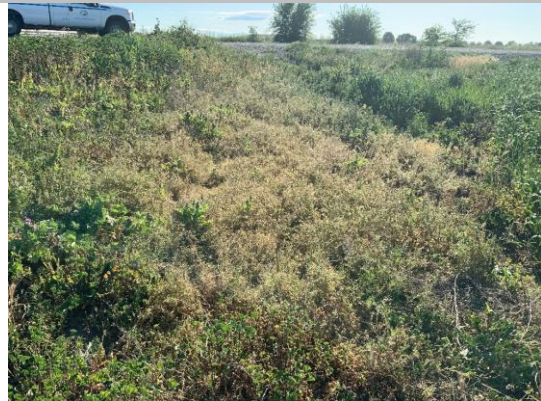
Photo 3 of 3 : UCIP_FA_2023_80420_96770.jpg

LS view: Slope from toe.

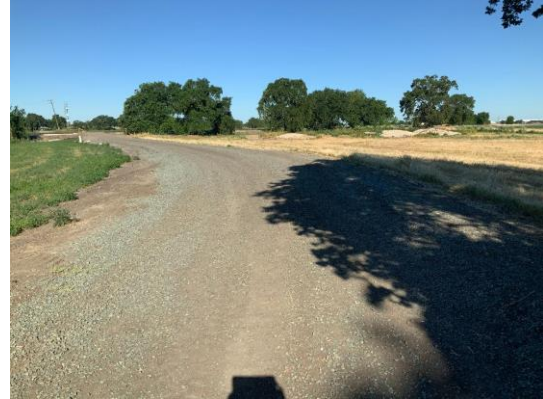
Photo 1 of 3 : UCIP_FA_2023_78235_96798.jpg

Comment Code					
Inspector Comment					
DS_ID:17973 FS_ID:78235 EP_NO: N/A Repair Type: Urgent EVAL Issue: 3a, Flood Risk Crossing Status: Found UCIP Comments: 04/27/2021 Pipe status is still Urgent. Slidegate no longer on WS, pipe is open on both ends. LS pipe edges are bent and warped. DWR DMP internal video inspection has found pipe integrity issues. LOF of crossing is between 4.1 and 5. Crossing will be monitored until funding becomes available for rehabilitation. Levee prism in this section appears to be less than 3 feet. No permit was found authorizing this encroachment. CVFPB will need to review crossing to determine owner. The UCIP inspection was completed with LMA representative, J. Nelson. (H. Dunn – GEI) 11/02/2018 Inlet deformed. Outlet missing a slide gate. The LMA states that a new slide gate will be installed in about two weeks. Inlet and outlet have dirt and vegetation issues. Crossing remains "Urgent" until a new slide gate is installed. Contact the LMA to see if they have photographic evidence that a new slide gate was put in. (A. McDonald - DWR UCIP)10/18/2018 Inlet deformed. Outlet missing a slide gate. This means that the pipe cannot be closed during high water. I have escalated this crossing from "No Action Needed" to "Urgent" due to the straight through pipe which could cause flooding during high water. There is a hole in the inlet, due to the deformity. It was most likely ran over by heavy equipment. I do not see enough evidence for an internal pipe inspection. (A. McDonald - DWR UCIP)03/25/2014 May need cleaning of mud in inlet pipe. (W. Wylie - DWR UCIP) FIELD_STRUCT_DESC: 24-inch corrugated metal drainage culvert (CMP) through the levee, 4.2 feet below the crown. Slide gate on the waterside (WS) end. [Additional Reference(s): DWR Levee Log, 1977, (HLM 1.00). USACE San Joaquin O&M Manual, Unit No. 613, Part C, May 1963, Revised 15 April 2010, (Station 98+65), 24-inch pipe listed. USACE As-Built File No. CA-2-6-147, Sheet No. 147/22, 25 March 1954, (Station 98+65)]. FS Date: 4/27/2021

Levee crown looking downstream.

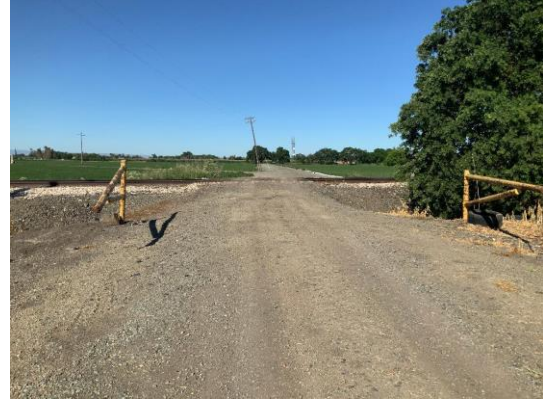
Photo 1 of 3 : UCIP_FA_2023_78236_96806.jpg

Comment Code						
Inspector Comment						
DS_ID:17972 FS_ID:78236 EP_NO: N/A Repair Type: Non-Urgent EVAL Issue: 11, Maintenance Compliance Issue Crossing Status: Found UCIP Comments: 04/27/2021 The record has been upgraded from No Action Needed to Non-Urgent. Some vegetation in front of WS flapgate, recommend removal. DWR DMP internal video inspection has not found pipe integrity issues. LOF of crossing is less or equal to 4.0. Recommend next video inspection in 5 years. Levee prism in this section appears to be less than 3 feet. No permit was found authorizing this encroachment. CVFPB will need to review crossing to determine owner. The UCIP inspection was completed with LMA representative, J. Nelson. (H. Dunn – GEI) 11/02/2018 Inlet and outlet cleared of dirt by the LMA. Crossing has been downgraded to "No Action Needed." (A. McDonald - DWR UCIP)03/25/2014 LS vegetation debris and mud on the inlet ditch and inside the pipe. (P. Amatya - DWR UCIP) FIELD_STRUCT_DESC: 1 of 2: 36-inch corrugated metal drainage pipe (CMP) through the levee, 6.6 feet below the crown. Flap gate on the waterside (WS) end. [Additional Reference(s): DWR Levee Log, 1977, (HLM 1.05). USACE San Joaquin O&M Manual, Unit No. 613, Part C, May 1963, Revised 15 April 2010, (Station 94+40), 36-inch pipe listed. USACE As-Built File No. CA-2-6-147, Sheet No. 147/22, 25 March 1954, (Station 94+40)]. FS Date: 4/27/2021

Levee crown looking downstream.

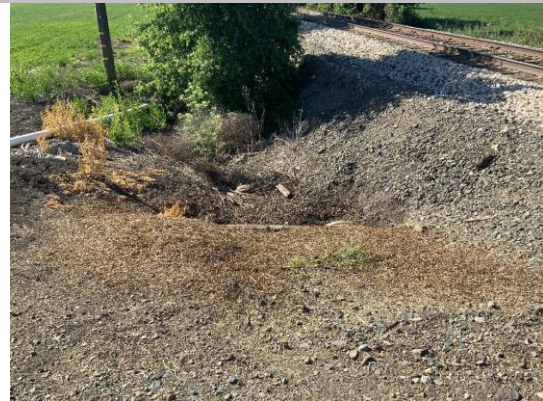
Photo 2 of 3 : UCIP_FA_2023_78236_96808.jpg

LS view: Headwall visible at toe from crown.

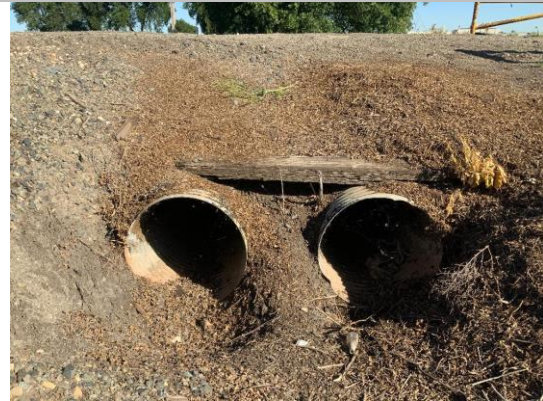
Photo 3 of 3 : UCIP_FA_2023_78236_96809.jpg

LM Start	0.79	Rating **	M	Issue No.	40 (cont)
LM End	0.79	Issue Type +	Ma	Location *	
Category	Supplemental		GPS Latitude/Longitude		
			Start	End	
Item	DWR UCIP LMA Responsibility		37.878502°	37.878502°	
			-121.242377°	-121.242377°	
DWR ID	17972

LS view: Headwall and pipe inlets at toe.

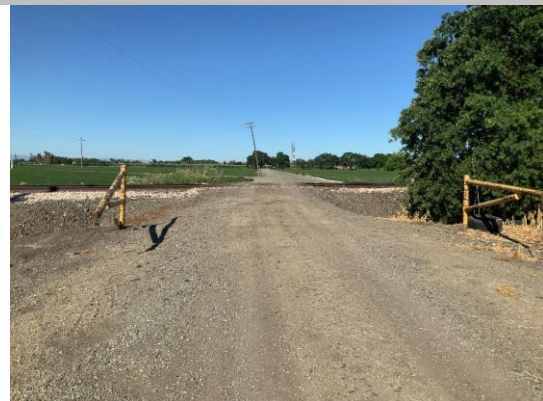
Photo 1 of 3 : UCIP_FA_2023_78237_96814.jpg

Levee crown looking downstream.

Comment Code					
Inspector Comment					
DS_ID:23995 FS_ID:78237 EP_NO: N/A Repair Type: Non-Urgent EVAL Issue: 5, Pipe Damage Crossing Status: Found UCIP Comments: 04/27/2021 The record has been upgraded from No Action Needed to Non-Urgent. DWR DMP internal video inspection has found pipe integrity issues. LOF of crossing is between 4.1 and 5. Crossing will be monitored until funding becomes available for rehabilitation. Vegetation covering WS flapgates, recommend removal. The levee prism in this section appears to be less than 3 feet. No permit was found authorizing this encroachment. CVFPB will need to review crossing to determine owner. The UCIP inspection was completed with LMA representative, J. Nelson. (H. Dunn – GE111/02/2018 Inlet and outlet covered in dirt. Inlet and outlet cleared of dirt by the LMA. (A. McDonald - DWR UCIP)03/25/2014 Needs cleaning and clearing of the culvert. (P. Amaty - DWR UCIP) FIELD_STRUCT_DESC: 2 of 2: 36-inch corrugated metal drainage pipe (CMP) through the levee, 6.6 feet below the crown. Flap gate on the waterside (WS) end. [Additional Reference(s): DWR Levee Log, 1977, (HLM 1.05). USACE San Joaquin O&M Manual, Unit No. 613, Part C, May 1963, Revised 15 April 2010, (Station 94+40), 36-inch pipe listed. USACE As-Built File No. CA-2-6-147, Sheet No. 147/22, 25 March 1954, (Station 94+40)]. FS Date: 4/27/2021

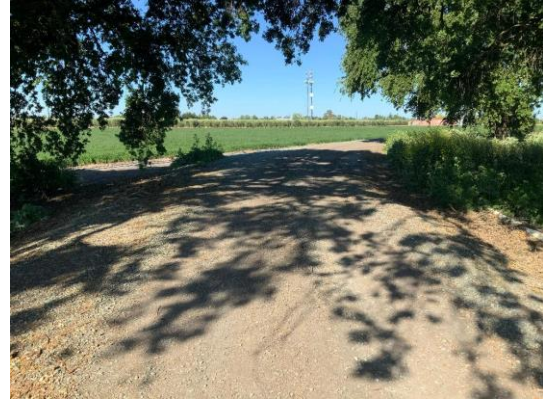
Photo 1 of 3 : UCIP_FA_2023_79413_96822.jpg

Comment Code					
Inspector Comment					
<p>DS_ID:23985 FS_ID:79413 EP_NO: N/A Repair Type: Non-Urgent EVAL Issue: 5, Pipe Damage Crossing Status: Found UCIP Comments: 03/31/2023 Record updated from Urgent to Non-Urgent. LoF is equal to 5 due to pipe surface damage corrosion, integrity issues are not found. Crossing will be monitored until funding becomes available for rehabilitation. (O.Yakimov - DWR UCIP) 04/27/2021 Record updated from No Action Needed to Urgent. DMP internal video inspection has found pipe integrity issues. LOF of crossing is between 5 and 6. Crossing will be monitored until funding becomes available to address the issues. LS and WS pipe end and flapgate both partially covered by vegetation debris, recommend removal. The levee prism in this section appears to be less than 3 feet. No permit was found authorizing this encroachment. CVFPB will need to review crossing to determine owner. The UCIP inspection was completed with LMA representative, J. Nelson. (H. Dunn ? GEI)</p> <p>11/02/2018 Inlet and outlet cleared of dirt and vegetation by the LMA. Crossing has been downgraded to "No Action Needed." (A. McDonald - DWR UCIP)03/25/2014 Debris and mud on inlet ditch and inside pipe. Needs cleaning and clearing the culvert. (P. Amatya - DWR UCIP) FIELD_STRUCT_DESC: 30-inch corrugated metal drainage pipe (CMP) through the levee, 11.0 feet below the crown. Flap gate on the waterside (WS) end. [Additional Reference(s): USACE San Joaquin O&M Manual, Unit No. 613, Part C, May 1963, Revised 15 April 2010, (Station 83+00), 30-inch pipe listed. USACE As-Built File No. CA-2-6-147, Sheet No. 147/1, 25 March 1954, (Station 83+00)]. FS Date: 4/27/2021</p>

Levee crown looking downstream.

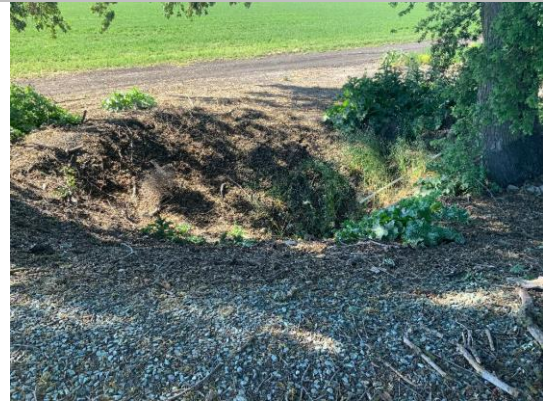
Photo 2 of 3 : UCIP_FA_2023_79413_96823.jpg

LM Start	1.02	Rating **	M	Issue No.	42 (cont)
LM End	1.02	Issue Type +	Ma	Location *	
Category	Supplemental			GPS Latitude/Longitude	
				Start	End
Item	DWR UCIP LMA Responsibility			37.877566°	37.877566°
				-121.246391°	-121.246391°
DWR ID	23985

LS view: Toe from crown.

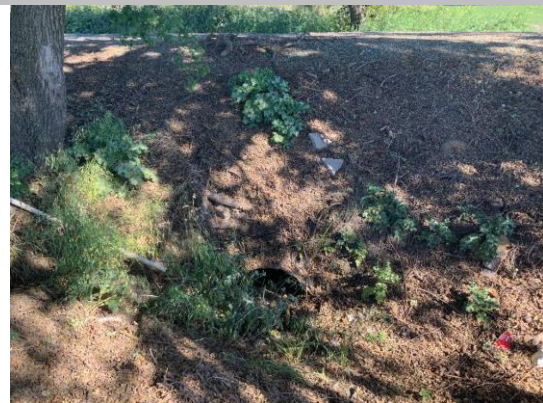
Photo 3 of 3 : UCIP_FA_2023_79413_96824.jpg

LS view: Pipe inlet at toe.

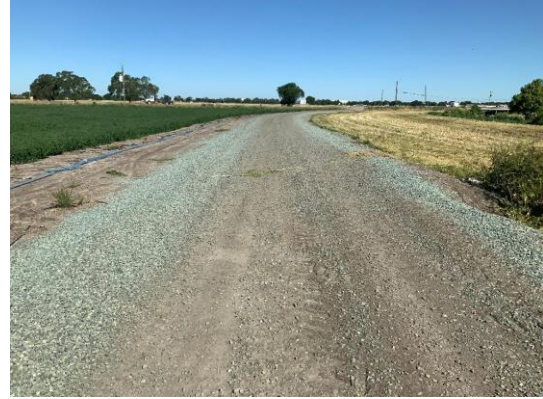
Photo 1 of 3 : UCIP_FA_2023_79414_96829.jpg

Comment Code					
Inspector Comment					
DS_ID:17970 FS_ID:79414 EP_NO: N/A Repair Type: Non-Urgent EVAL Issue: 5, Pipe Damage Crossing Status: Found UCIP Comments: 03/31/2023 Record updated from Urgent to Non-Urgent. LoF is equal to 5.1 due to pipe surface damage corrosion and deformed pipe end, integrity issues are not found. Crossing will be monitored until funding becomes available for rehabilitation. (O.Yakimov - DWR UCIP). 04/27/2021 The record has been upgraded from Non-Urgent to Urgent. DWR DMP internal video inspection has found pipe integrity issues. LOF of crossing is between 5 and 6. Crossing will be monitored until funding becomes available to address the issues. The levee prism in this section appears to be less than 3 feet. No permit was found authorizing this encroachment. CVFPB will need to review crossing to determine owner. The UCIP inspection was completed with LMA representative, J. Nelson. (H. Dunn ? GEI)11/02/2018 Inlet still deformed. Inlet and outlet cleared of dirt and vegetation by the LMA. Crossing continues to be rated "Non-Urgent." (A. McDonald - DWR UCIP)03/25/2014 Needs cleaning and clearing the culvert. (P. Amatya - DWR UCIP) FIELD_STRUCT_DESC: 24-inch corrugated metal drainage pipe (CMP) through the levee, 4.1 feet below the crown. Flap gate on the waterside (WS) end. [Additional Reference(s): DWR Levee Log, 1977, (HLM 1.44). USACE San Joaquin O&M Manual, Unit No. 613, Part C, May 1963, Revised 15 April 2010, (Station 76+60), 24-inch pipe listed. USACE As-Built File No. CA-2-6-147, Sheet No. 147/1, 25 March 1954, (Station 76+60)]. FS Date: 4/27/2021

Levee crown looking downstream.

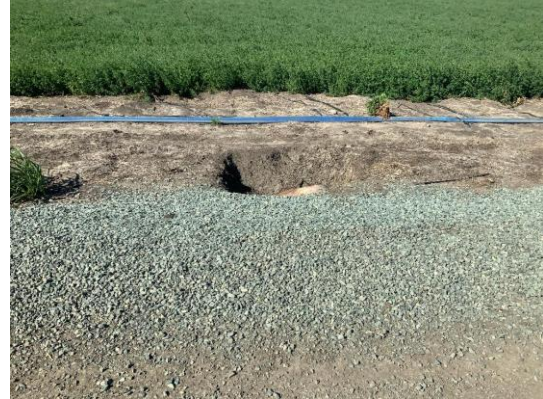
Photo 2 of 3 : UCIP_FA_2023_79414_96830.jpg

LM Start	1.18	Rating **	M	Issue No.	43 (cont)
LM End	1.18	Issue Type +	Ma	Location *	
Category	Supplemental			GPS Latitude/Longitude	
				Start	End
Item	DWR UCIP LMA Responsibility			37.879076°	37.879076°
				-121.248304°	-121.248304°
DWR ID	17970

LS view: Toe from crown.

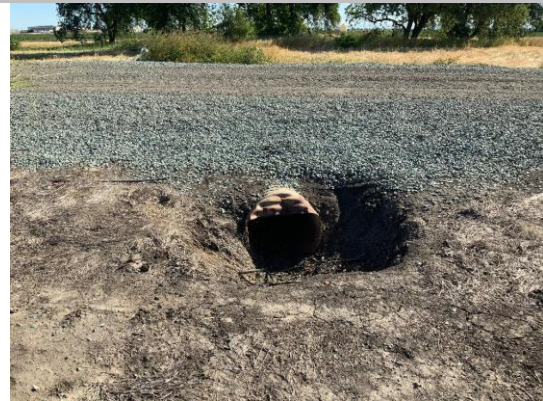
Photo 3 of 3 : UCIP_FA_2023_79414_96831.jpg

LS view: Pipe inlet at toe.

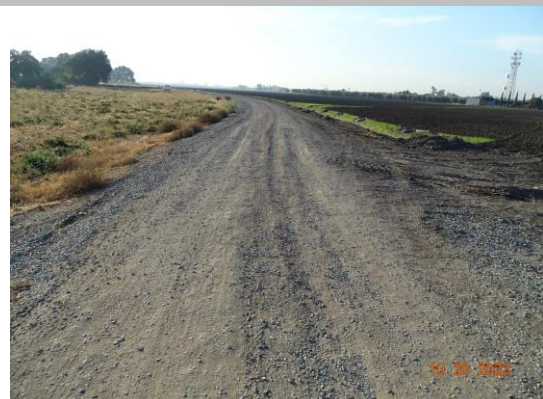
Photo 1 of 1 : FA_2023_NA0017_148_15_20231026_00037.jpg

LM Start	1.21	Rating **	M	Issue No.	15
LM End	1.27	Issue Type +	Ma	Location *	CR
Category	Earthen Levee			GPS Latitude/Longitude	
				Start	End
Item	Crown Surface / Depressions / Rutting			37.879431°	37.880320°
				-121.248656°	-121.249172°
DWR ID	DWR_NA0017_01_s_2023_15				
Comment Code					
C2 : Repair depressions or ruts in the crown or slope.					
Inspector Comment

View of ruts along the surface on levee crown. Fall 2023

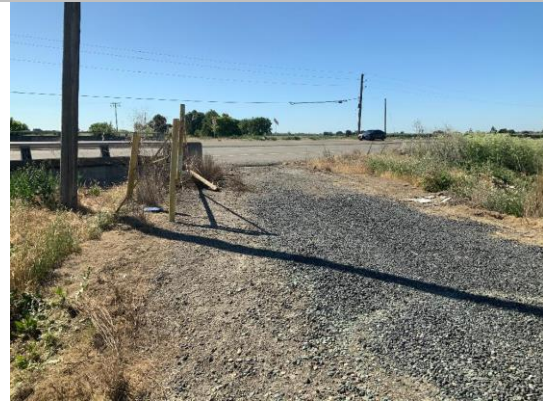
Photo 1 of 3 : UCIP_FA_2023_78240_96838.jpg

Comment Code					
Inspector Comment					
DS_ID:17969 FS_ID:78240 EP_NO: N/A Repair Type: Non-Urgent EVAL Issue: 10, Unauthorized Modification or Non-Compliant Permit Crossing Status: Indicator Found UCIP Comments: 04/27/2021 Pipe status is still Non-Urgent. This pipe appears abandoned, no standpipe on WS and no inlet structure on LS. Only pipe with appurtenance left on WS. Geophysical results did not confirm presence of pipe through levee. Record will remain in UCIP's inspection records until future Levee Improvement Project can confirm no crossing was found through the levee. The levee prism in this section appears to be less than 3 feet. This crossing was identified as a System Feature. The UCIP inspection was completed with LMA representative, J. Nelson. (H. Dunn – GEI) 03/25/2014 Appears abandoned and should be verified as having been done so properly. (P. Tariq - DWR UCIP) Concrete standpipe on waterside. Abandoned gate valve on waterside. Steel pipe disconnected with the standpipe. Inlet structure with steel gates and 18-inch alfalfa valve on landside. FIELD_STRUCT_DESC: 18-inch reinforced concrete drainage pipe (RCP) through the levee, 6.2 feet below the crown. [Additional Reference(s): DWR Levee Log, 1977, (HLM 1.60). USACE San Joaquin O&M Manual, Unit No. 613, Part C, May 1963, Revised 15 April 2010, (Station 68+90), 18-inch pipe listed. USACE As-Built File No. CA-2-6-147, Sheet No. 147/1, 25 March 1954, (Station 68+90), 21-inch pipe listed]. FS Date: 4/27/2021

Levee crown looking upstream.

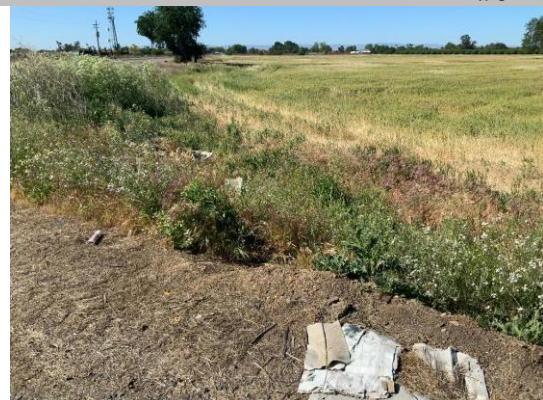
Photo 2 of 3 : UCIP_FA_2023_78240_96842.jpg

LS view: Slope from crown, no inlet structure seen.

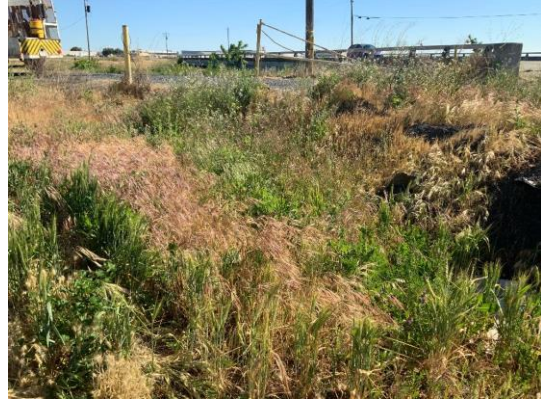
Photo 3 of 3 : UCIP_FA_2023_78240_96843.jpg

LM Start	1.33	Rating **	M	Issue No.	44 (cont)
LM End	1.33	Issue Type +	Ma	Location *	
Category	Supplemental			GPS Latitude/Longitude	
				Start	End
Item	DWR UCIP LMA Responsibility			37.881077°	37.881077°
				-121.249368°	-121.249368°
DWR ID	17969

LS view: Slope from toe, no inlet structure seen.

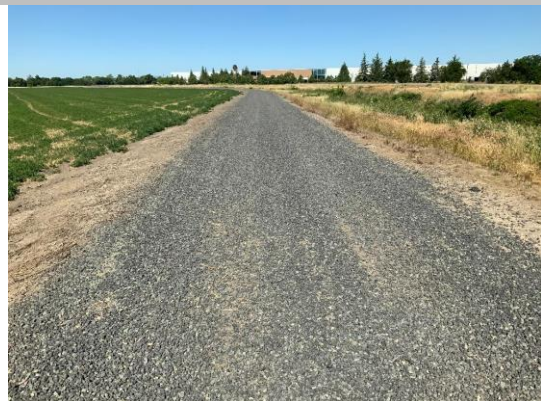
Photo 1 of 3 : UCIP_FA_2023_78241_96854.jpg

DS_ID:17968
FS_ID:78241
EP_NO: N/A
Repair Type: Non-Urgent
EVAL Issue:
Crossing Status: Indicator Found
UCIP Comments: 04/27/2021 The record has been upgraded from No Action Needed to Non-Urgent. Pipe not found by visual inspection. No permit was found authorizing this encroachment. CVFPB will need to review crossing to determine owner. The UCIP inspection was completed with LMA representative, J. Nelson. (H. Dunn – GEI)
FIELD_STRUCT_DESC: 24-inch corrugated metal drainage pipe (CMP) through the levee, 5.3 feet below the crown. Flap gate on the waterside (WS) end. [Additional Reference(s): DWR Levee Log, 1977, (HLM 1.96). USACE San Joaquin O&M Manual, Unit No. 613, Part C, May 1963, Revised 15 April 2010, (Station 50+00), 24-inch pipe listed. USACE As-Built File No. CA-2-6-147, Sheet No. 147/1, 25 March 1954, (Station 50+00)].
FS Date: 4/27/2021

Levee crown looking downstream.

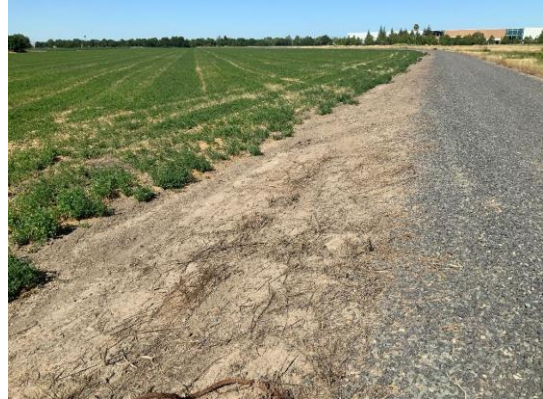
Photo 2 of 3 : UCIP_FA_2023_78241_96855.jpg

LM Start	1.69	Rating **	M	Issue No.	45 (cont)
LM End	1.69	Issue Type +	Ma	Location *	
Category	Supplemental			GPS Latitude/Longitude	
				Start	End
Item	DWR UCIP LMA Responsibility			37.884636°	37.884636°
				-121.254161°	-121.254161°
DWR ID	17968

LS view: Slope from crown, no pipe visible.

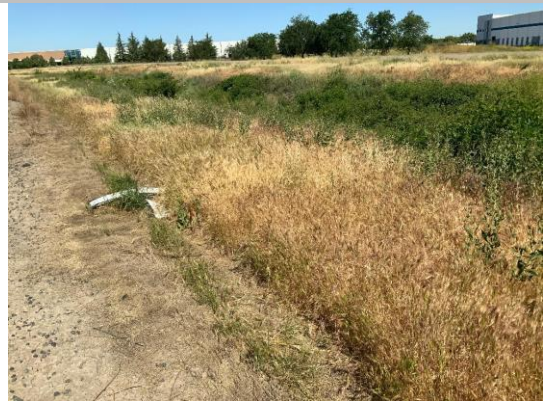
Photo 3 of 3 : UCIP_FA_2023_78241_96856.jpg

WS view: Slope from crown, no pipe visible.

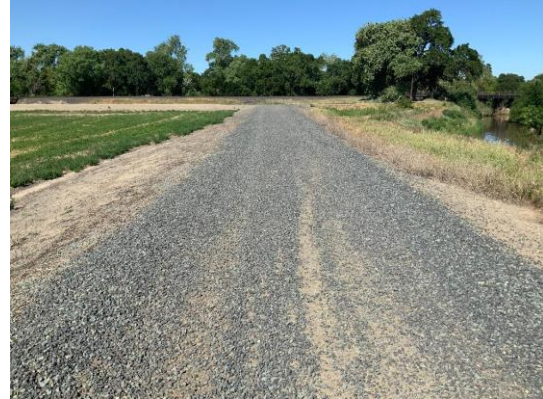
Photo 1 of 3 : UCIP_FA_2023_78852_96871.jpg

Comment Code						
Inspector Comment						
DS_ID:17966						
FS_ID:78852						
EP_NO: N/A						
Repair Type: Non-Urgent						
EVAL Issue: 11, Maintenance Compliance Issue						
Crossing Status: Found						
UCIP Comments: 04/27/2021 The record has been upgraded from No Action Needed to Non-Urgent. WS flapgate completely covered in vegetation and LS inlet has some sediment buildup inside, recommend cleaning on both ends. DWR DMP internal video inspection has not found pipe integrity issues. LOF of crossing is less or equal to 4.0. Recommend next video inspection in 5 years No permit was found authorizing this encroachment. CVFPB will need to review crossing to determine owner. The levee prism in this section appears to be less than 3 feet. The UCIP inspection was completed with LMA representative, J. Nelson. (H. Dunn – GEI) 11/02/2018 Inlet uncovered from the dirt by the LMA. Some vegetation at the flap gate. Crossing continues to be rated "No Action Needed." (A. McDonald - DWR UCIP)03/25/2014 Grouted riprap outlet box and concrete outfall pipe on waterside. Pipe not visible on landside. (P. Amatya - DWR UCIP)

FIELD_STRUCT_DESC: 24-inch corrugated metal drainage pipe (CMP) through the levee, 5.0 feet below the crown. Flap gate on the waterside (WS) end. Grouted riprap outlet box and concrete outfall pipe on the WS. [Additional Reference(s): DWR Levee Log, 1977, (HLM 2.82). USACE San Joaquin O&M Manual, Unit No. 613, Part C, May 1963, Revised 15 April 2010, (Station 4+00), 24-inch pipe listed. USACE As-Built File No. CA-2-6-147, Sheet No. 147/1, 25 March 1954, (Station 4+00)].						
FS Date: 4/27/2021

Levee crown looking downstream.

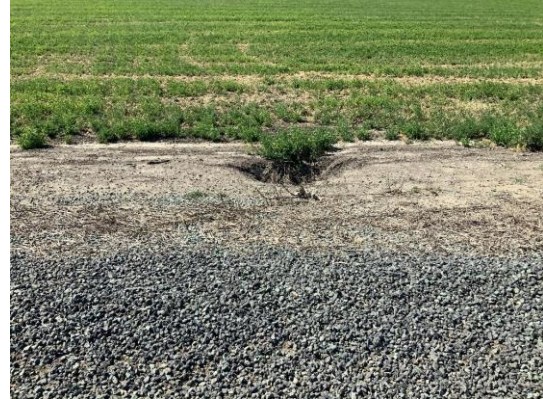
Photo 2 of 3 : UCIP_FA_2023_78852_96872.jpg

LM Start	2.53	Rating **	M	Issue No.	46 (cont)
LM End	2.53	Issue Type +	Ma	Location *	
Category	Supplemental			GPS Latitude/Longitude	
				Start	End
Item	DWR UCIP LMA Responsibility			37.888080°	37.888080°
				-121.266631°	-121.266631°
DWR ID	17966

LS view: Slope from crown.

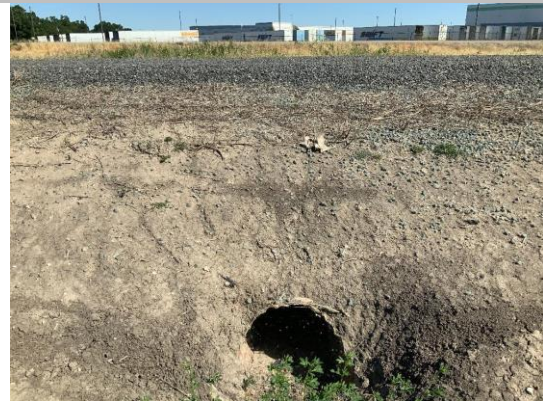
Photo 3 of 3 : UCIP_FA_2023_78852_96873.jpg

LS view: Pipe inlet at toe.

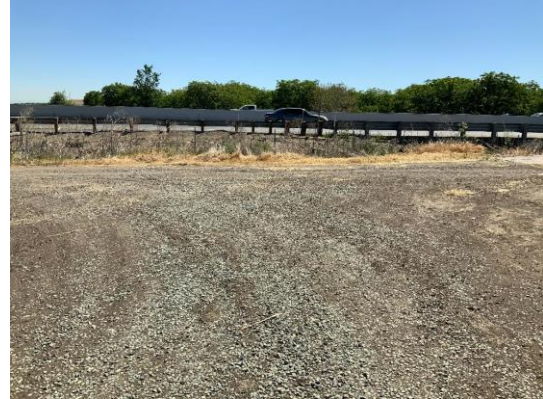
Photo 1 of 3 : UCIP_FA_2023_78244_96979.jpg

Comment Code					
Inspector Comment					
DS_ID:23987 FS_ID:78244 EP_NO: N/A Repair Type: Non-Urgent EVAL Issue: Crossing Status: Not Found UCIP Comments: 04/28/2021 Pipe status is still Non-Urgent. Pipe not found in the field. No permit was found authorizing this encroachment. CVFPB will need to review crossing to determine owner. The UCIP inspection was completed with LMA representative, J. Nelson. (H. Dunn – GEI) 04/02/2014 Not found: 24-inch CM pipe with flap gate on waterside of the levee. O&M Manual May 1963 (SJR 613C Vol 15). Probably, the pipe mentioned in desk study is one across the channel on other bank of the creek. Needs confirmation from DWR inspector or LMA. (P. Amatya - DWR) FIELD_STRUCT_DESC: 24-inch corrugated metal gravity drainage pipe (CMP) through the levee, invert elevation 25.0 feet. Flap gate on the waterside (WS) end. [Additional Reference(s): USACE San Joaquin O&M Manual, Unit No. 613, Part C, May 1963, Revised 15 April 2010, (Station 176+80 "N"), 24-inch pipe listed. USACE As-Built File No. CA-2-6-147, Sheet No. 147/2, 25 March 1954, (Station 176+80 "N")]. FS Date: 4/28/2021

Levee crown looking upstream.

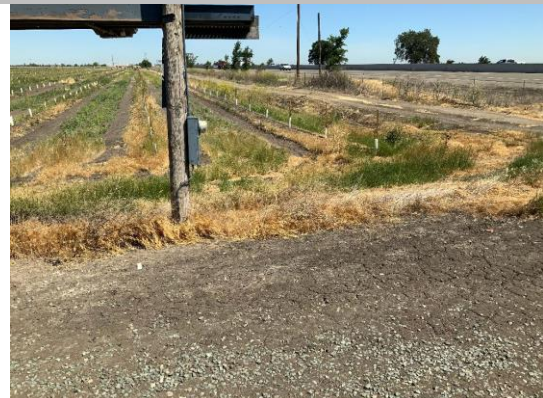
Photo 2 of 3 : UCIP_FA_2023_78244_96980.jpg

LS view: Slope from crown, no pipe visible.

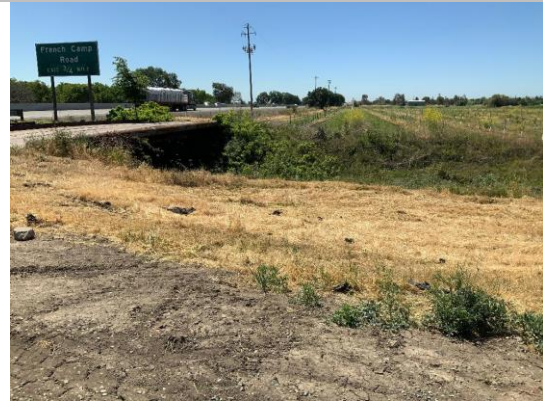
Photo 3 of 3 : UCIP_FA_2023_78244_96981.jpg

WS view: Slope from crown, no pipe visible.

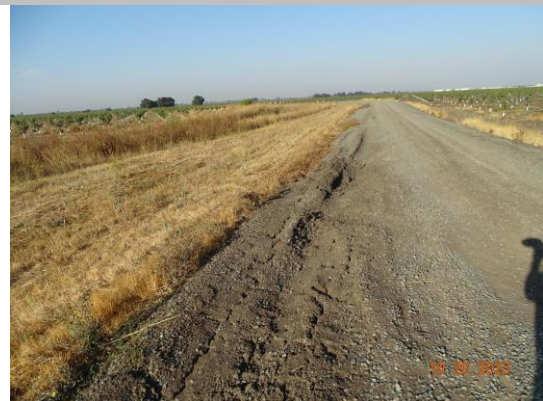
Photo 1 of 1 : FA_2023_NA0017_149_19_20231026_00045.jpg

LM Start	0.02	Rating **	M	Issue No.	19
LM End	0.02	Issue Type +	Ma	Location *	CR
Category	Earthen Levee			GPS Latitude/Longitude	
				Start	End
Item	Crown Surface / Depressions / Rutting			37.875137°	37.875137°
				-121.220320°	-121.220320°
DWR ID	DWR_NA0017_02_f_2023_19				
Comment Code					
C2 : Repair depressions or ruts in the crown or slope.					
Inspector Comment

View of ruts along the surface road of the levee crown. Fall 2023

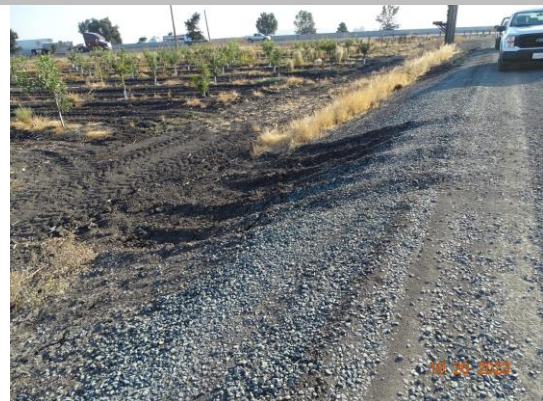
Photo 1 of 1 : FA_2023_NA0017_149_21_20231026_00046.jpg

LM Start	0.03	Rating **	M	Issue No.	21
LM End	0.03	Issue Type +	Ma	Location *	LS
Category	Earthen Levee			GPS Latitude/Longitude	
				Start	End
Item	Erosion / Vehicle Traffic			37.875173°	37.875173°
				-121.220615°	-121.220615°
DWR ID	DWR_NA0017_02_f_2023_21				
Comment Code					
E6 : Repair the levee slope damaged by vehicle traffic and prevent access where possible.					
Inspector Comment					
Landside slope depressions caused by farming equipment.

View of ruts along the landside slope caused by farming equipment. Fall 2023

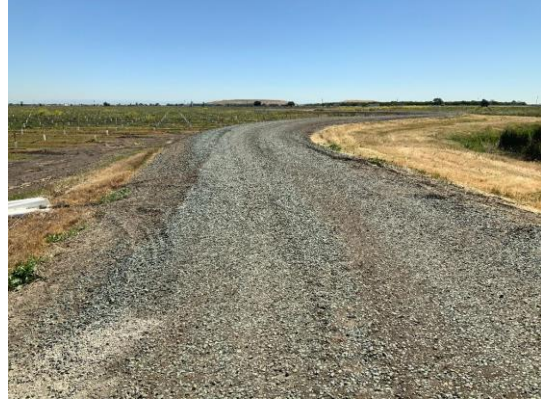
Photo 1 of 3 : UCIP_FA_2023_78245_96992.jpg

Comment Code						
Inspector Comment						
DS_ID:17986 FS_ID:78245 EP_NO: N/A Repair Type: Urgent EVAL Issue: 3a, Flood Risk Crossing Status: Found UCIP Comments: 04/28/2021 The record has been upgraded from No Action Needed to Urgent. No flapgate on the WS, pipe is open on both ends. There is an 8inch plastic pipe now going through this metal pipe that looks to go underground possibly under the channel on WS. Need more information from owner. No permit was found authorizing this encroachment. CVFPB will need to review crossing to determine owner. The UCIP inspection was completed with LMA representative, J. Nelson. (H. Dunn – GEI) 11/02/2018 Inlet cleared of dirt and vegetation by the LMA. Crossing continues to be rated "No Action Needed." (A. McDonald - DWR UCIP)04/02/2014 May need cleaning. (P. Amatya - DWR UCIP) FIELD_STRUCT_DESC: 24-inch corrugated metal gravity drainage pipe (CMP) through the levee, 5.0 feet below the crown. Flap gate on the waterside (WS) end. [Additional Reference(s): DWR Levee Log, 1977, (HLM 0.50). USACE San Joaquin O&M Manual, Unit No. 613, Part C, May 1963, Revised 15 April 2010, (Station 148+18 "N"), 24-inch pipe listed. USACE As-Built File No. CA-2-6-147, Sheet No. 147/2, 25 March 1954, (Station 148+18 "N"))]. FS Date: 4/28/2021

Levee crown looking upstream.

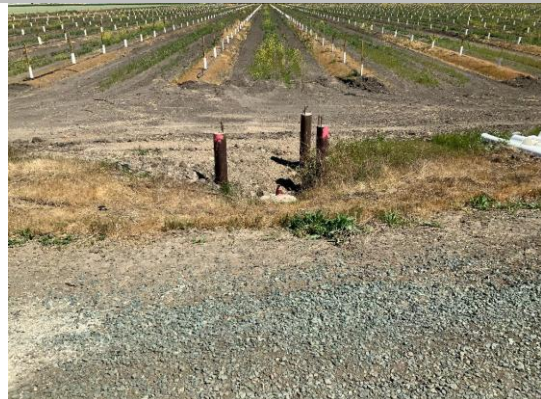
Photo 2 of 3 : UCIP_FA_2023_78245_96994.jpg

LS view: Pipe end visible at toe from crown.

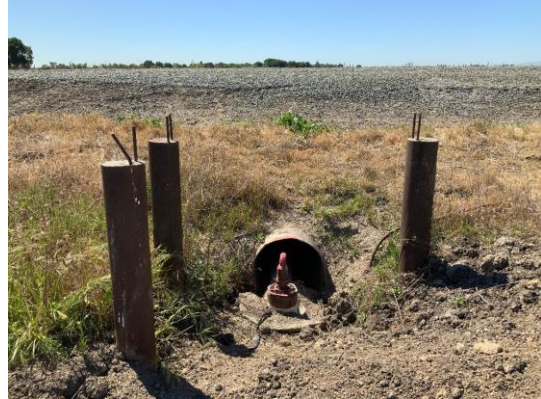
Photo 3 of 3 : UCIP_FA_2023_78245_96995.jpg

LS view: Pipe inlet at toe.

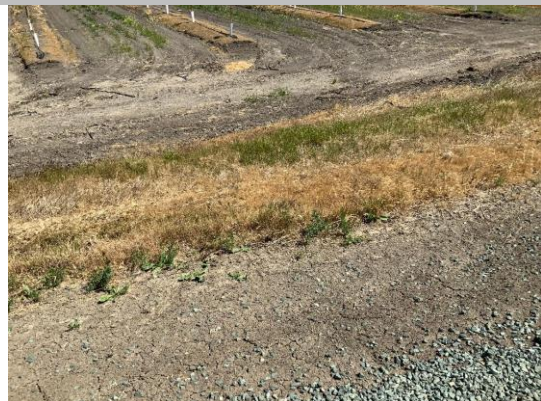
Photo 1 of 3 : UCIP_FA_2023_78246_96997.jpg

DS_ID:23986
 FS_ID:78246
 EP_NO: N/A
 Repair Type: Non-Urgent
 EVAL Issue:
 Crossing Status: Not Found
 UCIP Comments: 04/28/2021 The record has been upgraded from No Action Needed to Non-Urgent. Pipe not found by visual inspection. No permit was found authorizing this encroachment. CVFPB will need to review crossing to determine owner. The UCIP inspection was completed with LMA representative, J. Nelson. (H. Dunn – GEI)
 FIELD_STRUCT_DESC: 10-inch steel drainage discharge pipe through the levee, 2.0 feet below the crown. Gate valve on the waterside (WS). Pump structure on the landside (LS). [Additional Reference(s): USACE San Joaquin O&M Manual, Unit No. 613, Part C, May 1963, Revised 15 April 2010, (Station 148+18 "N"), 10-inch pipe listed. USACE As-Built File No. CA-2-6-147, Sheet No. 147/2, 25 March 1954, (Station 148+18 "N")].
 FS Date: 4/28/2021

LS view: Slope and toe from crown, no pipe visible.

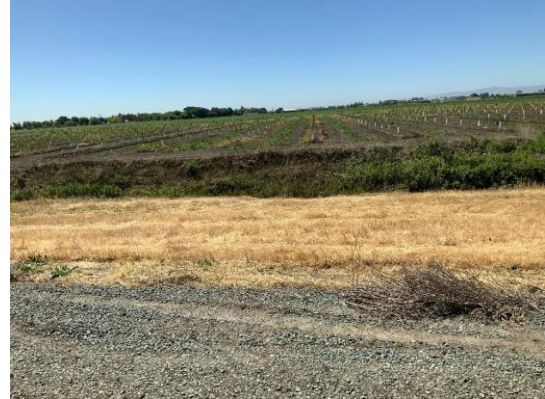
Photo 2 of 3 : UCIP_FA_2023_78246_96998.jpg

WS view: Slope from crown, no pipe visible.

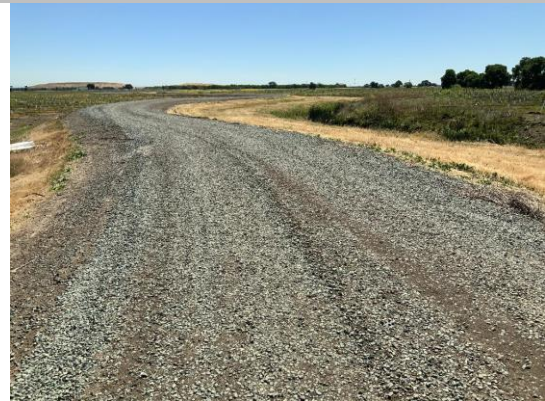
Photo 3 of 3 : UCIP_FA_2023_78246_96999.jpg

Levee crown looking upstream.

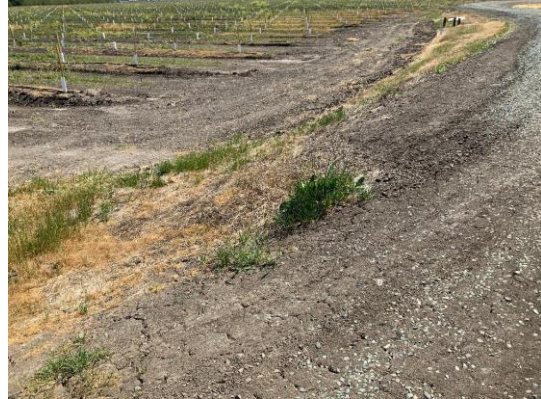
Photo 1 of 3 : UCIP_FA_2023_78247_97000.jpg

Comment Code					
Inspector Comment					
DS_ID:23982 FS_ID:78247 EP_NO: N/A Repair Type: Non-Urgent EVAL Issue: Crossing Status: Not Found UCIP Comments: 04/28/2021 The record has been upgraded from No Action Needed to Non-Urgent. Pipe not found by visual inspection. No permit was found authorizing this encroachment. CVFPB will need to review crossing to determine owner. The UCIP inspection was completed with LMA representative, J. Nelson. (H. Dunn – GEI) FIELD_STRUCT_DESC: 24-inch corrugated metal gravity drainage pipe (CMP) through the levee, invert elevation 24.0 feet. Flap gate on the waterside (WS) end. [Additional Reference(s): USACE San Joaquin O&M Manual, Unit No. 613, Part C, May 1963, Revised 15 April 2010, (Station 146+40 "N"), 24-inch pipe listed. USACE As-Built File No. CA-2-6-147, Sheet No. 147/2, 25 March 1954, (Station 146+40 "N")]. FS Date: 4/28/2021

LS view: Slope from crown, no pipe visible.

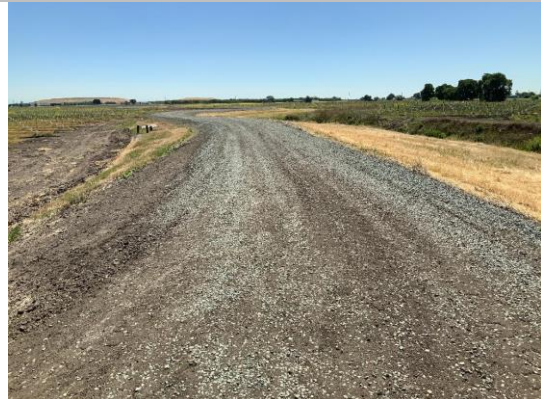
Photo 2 of 3 : UCIP_FA_2023_78247_97001.jpg

Levee crown looking upstream.

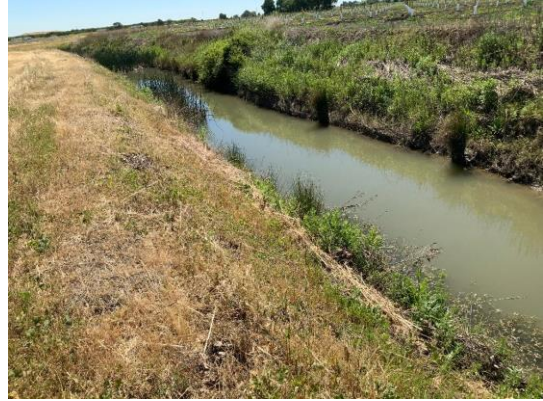
Photo 3 of 3 : UCIP_FA_2023_78247_97002.jpg

WS view: Slope from berm, no pipe visible.

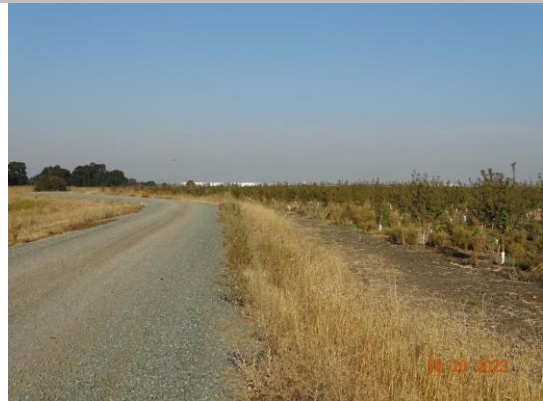
Photo 1 of 1 : FA_2023_NA0017_149_16_20231026_00047.jpg

LM Start	0.58	Rating **	M	Issue No.	16
LM End	0.98	Issue Type +	Ma	Location *	LS
Category	Earthen Levee			GPS Latitude/Longitude	
				Start	End
Item	Vegetation			37.875295°	37.877108°
				-121.229950°	-121.235618°
DWR ID	DWR_NA0017_02_f_2023_16				
Comment Code					
V1 : Control annual grass and weeds on the levee slopes and easements.					
Inspector Comment

View of vegetation along landside slope. Fall 2023

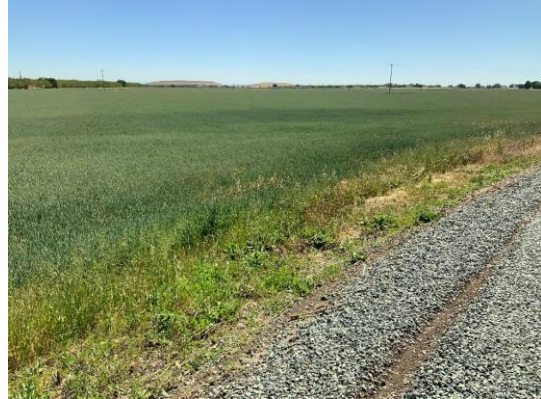
Photo 1 of 3 : UCIP_FA_2023_78248_97006.jpg

Comment Code					
Inspector Comment					
DS_ID:17984 FS_ID:78248 EP_NO: N/A Repair Type: Non-Urgent EVAL Issue: Crossing Status: Indicator Found UCIP Comments: 08/31/2022 Erosion at both ends of the pipe. (A. McDonald - DWR UCIP)04/28/2021 The record has been upgraded from No Action Needed to Non-Urgent. Pipe not found by visual inspection. No permit was found authorizing this encroachment. CVFPB will need to review crossing to determine owner. The UCIP inspection was completed with LMA representative, J. Nelson. (H. Dunn – GEI) FIELD_STRUCT_DESC: 24-inch corrugated metal gravity drainage pipe (CMP) through the levee, 8.0 feet below the crown. Flap gate on the waterside (WS) end. [Additional Reference(s): DWR Levee Log, 1977, (HLM 0.84). USACE San Joaquin O&M Manual, Unit No. 613, Part C, May 1963, Revised 15 April 2010, (Station 129+55 "N"), 24-inch pipe listed. USACE As-Built File No. CA-2-6-147, Sheet No. 147/2, 25 March 1954, (Station 129+55 "N"))]. FS Date: 4/28/2021

LS view: Slope from crown, no pipe visible.

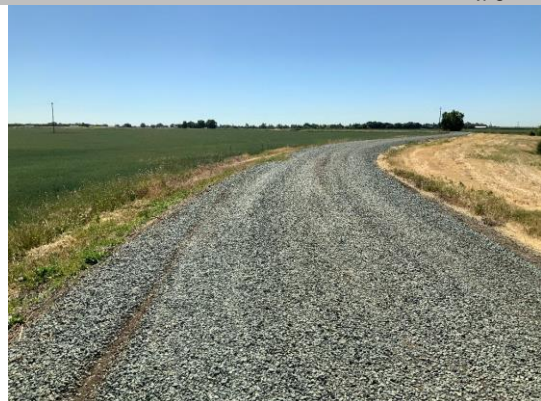
Photo 2 of 3 : UCIP_FA_2023_78248_97007.jpg

Levee crown looking upstream.

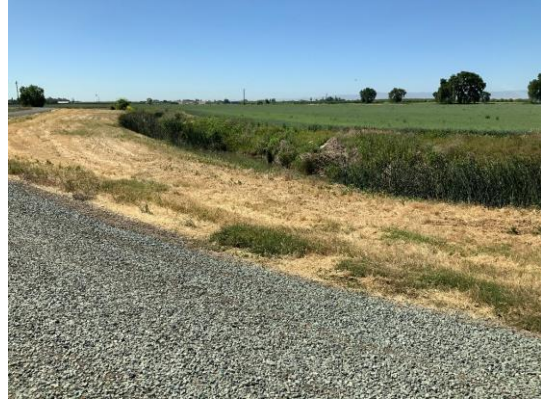
Photo 3 of 3 : UCIP_FA_2023_78248_97008.jpg

WS view: Slope from crown, no pipe visible.

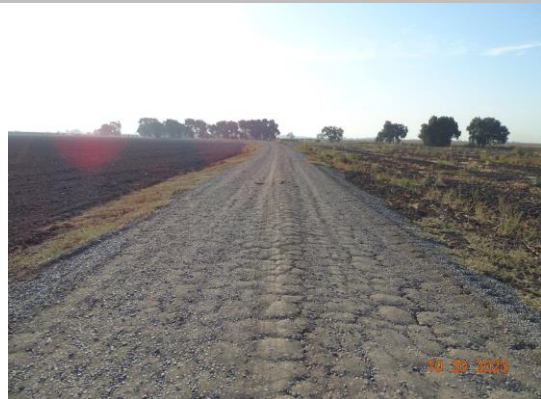
Photo 1 of 1 : FA_2023_NA0017_149_20_20231026_00044.jpg

LM Start	0.98	Rating **	M	Issue No.	20
LM End	1.25	Issue Type +	Ma	Location *	CR
Category	Earthen Levee			GPS Latitude/Longitude	
				Start	End
Item	Crown Surface / Depressions / Rutting			37.877102°	37.878971°
				-121.235637°	-121.239712°
DWR ID	DWR_NA0017_02_s_2023_20				
Comment Code					
C2 : Repair depressions or ruts in the crown or slope.					
Inspector Comment

View of ruts along the surface road of the levee crown. Fall 2023

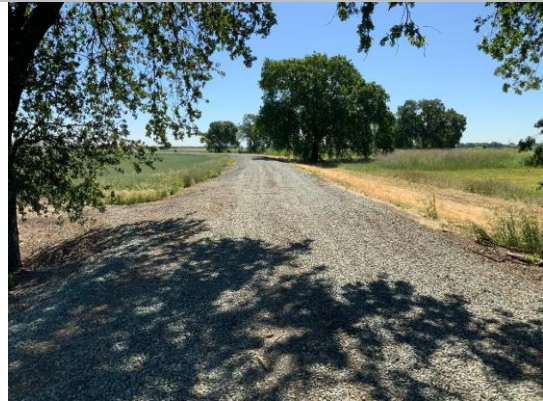
Photo 1 of 3 : UCIP_FA_2023_78249_97012.jpg

Comment Code						
Inspector Comment						
DS_ID:17983 FS_ID:78249 EP_NO: N/A Repair Type: Non-Urgent EVAL Issue: Crossing Status: Found UCIP Comments: 04/28/2021 The record has been upgraded from No Action Needed to Non-Urgent. No permit was found authorizing this encroachment. CVFPB will need to review crossing to determine owner. The UCIP inspection was completed with LMA representative, J. Nelson. (H. Dunn – GEI) 11/02/2018 Inlet and outlet cleared of dirt and vegetation by the LMA. Crossing has been downgraded to "No Action Needed." (A. McDonald - DWR UCIP)04/02/2014 Needs cleaning and clearing the culvert. (P. Amatya - DWR UCIP) FIELD_STRUCT_DESC: 24-inch corrugated metal gravity drainage pipe (CMP) through the levee, 6.4 feet below the crown. Flap gate on the waterside (WS) end. [Additional Reference(s): DWR Levee Log, 1977, (HLM 1.08). USACE San Joaquin O&M Manual, Unit No. 613, Part C, May 1963, Revised 15 April 2010, (Station 114+50), 24-inch pipe listed. USACE As-Built File No. CA-2-6-147, Sheet No. 147/2, 25 March 1954, (Station 114+50)]. FS Date: 4/28/2021

Levee crown looking upstream.

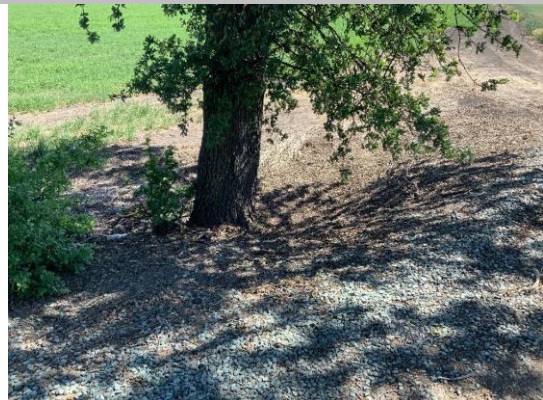
Photo 2 of 3 : UCIP_FA_2023_78249_97013.jpg

LS view: Slope and toe from crown.

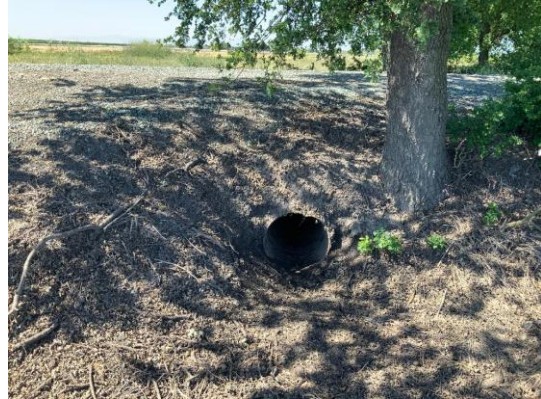
Photo 3 of 3 : UCIP_FA_2023_78249_97014.jpg

LS view: Slope and pipe inlet at toe.

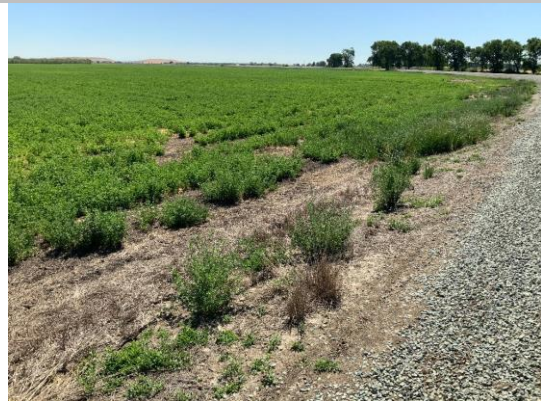
Photo 1 of 3 : UCIP_FA_2023_78250_97016.jpg

DS_ID:23983
 FS_ID:78250
 EP_NO: N/A
 Repair Type: Non-Urgent
 EVAL Issue:
 Crossing Status: Indicator Found
 UCIP Comments: 04/28/2021 Record has been upgraded from No Action Needed to Non-Urgent. Unit 2 – Littlejohn Creek (CLM 1.20 to 1.70) is considered a patrol road/high ground area with no defined levee prism, any issue found between CLM 1.20-1.70 of Unit 2 will be considered a maintenance issue, or an unauthorized encroachment, or an abandoned encroachment. Current condition of pipe crossing does not impede access to patrol road/high ground area. Pipe not found by visual inspection. No permit was found authorizing this encroachment. CVFPB will need to review crossing to determine owner. The UCIP inspection was completed with LMA representative, J. Nelson. (H. Dunn – GEI)
 FIELD_STRUCT_DESC: 24-inch corrugated metal gravity drainage pipe (CMP) through the levee, 5.0 feet below the crown. Flap gate on the waterside (WS) end. [Additional Reference(s): USACE San Joaquin O&M Manual, Unit No. 613, Part C, May 1963, Revised 15 April 2010, (Station 104+00), 24-inch pipe listed. USACE As-Built File No. CA-2-6-147, Sheet No. 147/22, 25 March 1954, (Station 104+00)].

LS view: Slope from crown, no pipe visible.

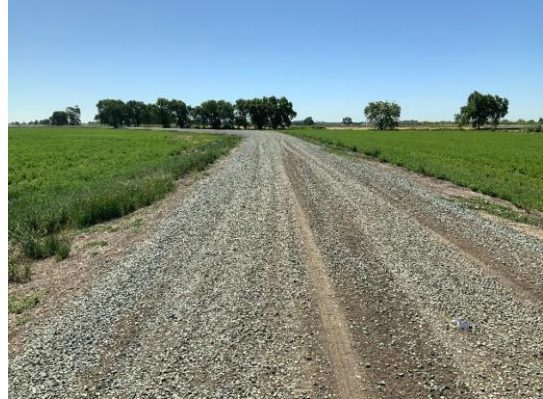
Photo 2 of 3 : UCIP_FA_2023_78250_97017.jpg

Levee crown looking upstream.

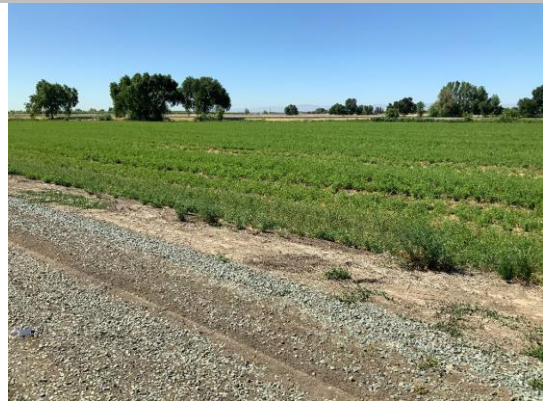
Photo 3 of 3 : UCIP_FA_2023_78250_97018.jpg

WS view: Slope from toe, no pipe visible.

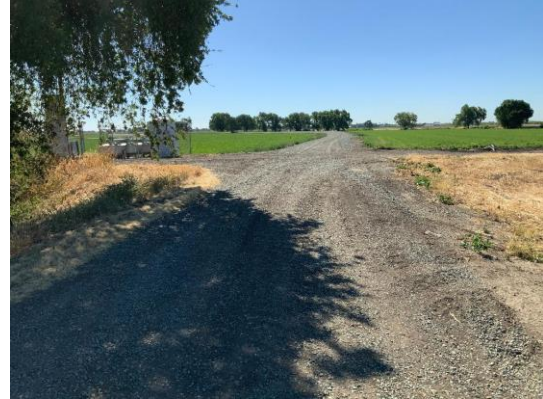
Photo 1 of 3 : UCIP_FA_2023_78253_97027.jpg

Comment Code						
Inspector Comment						
DS_ID:17982 FS_ID:78253 EP_NO: N/A Repair Type: Non-Urgent EVAL Issue: Crossing Status: Indicator Found UCIP Comments: 04/28/2021 Record has been upgraded from No Action Needed to Non-Urgent. Unit 2 – Littlejohn Creek (CLM 1.20 to 1.70) is considered a patrol road/high ground area with no defined levee prism, any issue found between CLM 1.20-1.70 of Unit 2 will be considered a maintenance issue, or an unauthorized encroachment, or an abandoned encroachment. Current condition of pipe crossing does not impede access to patrol road/high ground area. No permit was found authorizing this encroachment. CVFPB will need to review crossing to determine owner. The UCIP inspection was completed with LMA representative, J. Nelson. (H. Dunn – GEI) 04/02/2014 Pipe submerged into the water. (P. David - DWR UCIP) FIELD_STRUCT_DESC: 30-inch corrugated metal gravity drainage pipe (CMP) through the levee, 11.5 feet below the crown. Slide gate in a 42-inch CMP riser unit/pipe well on the waterside (WS) slope. [Additional Reference(s): DWR Levee Log, 1977, (HLM 1.29). USACE San Joaquin O&M Manual, Unit No. 613, Part C, May 1963, Revised 15 April 2010, (Station 100+60), 30-inch pipe listed. USACE As-Built File No. CA-2-6-147, Sheet No. 147/22, 25 March 1954, (Station 100+60)]. FS Date: 4/28/2021

Levee crown looking upstream.

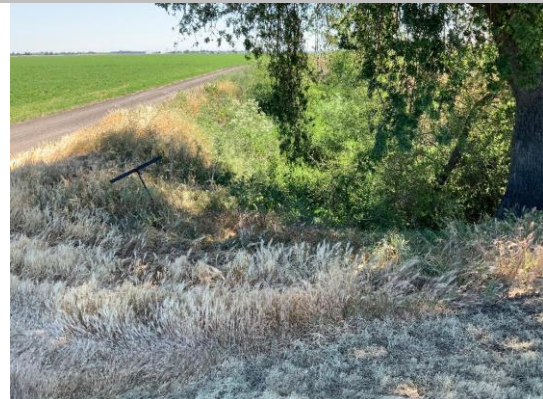
Photo 2 of 3 : UCIP_FA_2023_78253_97031.jpg

LS view: Slope from crown.

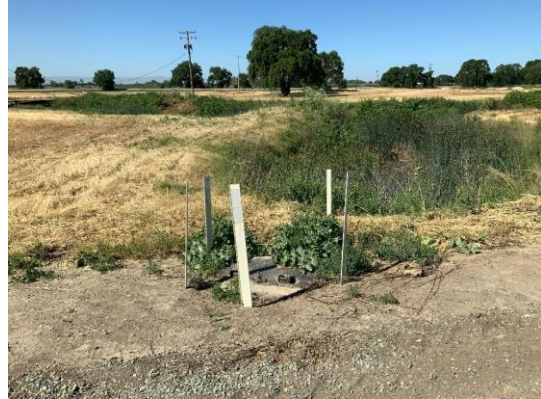
Photo 3 of 3 : UCIP_FA_2023_78253_97028.jpg

WS view: Manhole visible on crown.

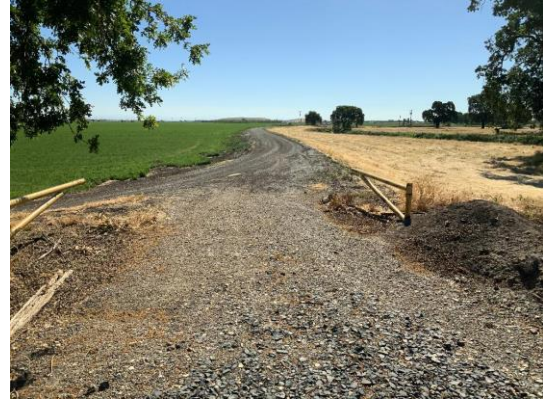
Photo 1 of 3 : UCIP_FA_2023_78254_97051.jpg

Comment Code					
Inspector Comment					
DS_ID:23984 FS_ID:78254 EP_NO: N/A Repair Type: Non-Urgent EVAL Issue: Crossing Status: Found UCIP Comments: 05/06/2022 According to USACE As-Built File No. CA-2-6-147, Sheet No. 147/22, 25 March 1954, at Station 93+00 there was an existing 12-inch steel pipe (DSID 24008) that was removed and replaced with a 24-inch CMP (DSID 23984). (A. McDonald - DWR UCIP)04/28/2021 Record has been upgraded from No Action Needed to Non-Urgent. Unit 2 – Littlejohn Creek (CLM 1.20 to 1.70) is considered a patrol road/high ground area with no defined levee prism, any issue found between CLM 1.20-1.70 of Unit 2 will be considered a maintenance issue, or an unauthorized encroachment, or an abandoned encroachment. DWR DMP internal video inspection has not found pipe integrity issues. LOF of crossing is less or equal to 4.0. Recommend next video inspection in 5 years. Minor warping of LS pipe edges. Current condition of pipe crossing does not impede access to patrol road/high ground area. No permit was found authorizing this encroachment. CVFPB will need to review crossing to determine owner. The UCIP inspection was completed with LMA representative, J. Nelson. (H. Dunn – GEI) 11/02/2018 Inlet and outlet cleared of dirt and vegetation by the LMA. Crossing continues to be rated "No Action Needed." (A. McDonald - DWR UCIP)04/02/2014 May need cleaning. (P. Amatya - DWR UCIP) FIELD_STRUCT_DESC: 24-inch corrugated metal gravity drainage pipe (CMP) through the levee, 7.8 feet below the crown. Flap gate on the waterside (WS) end. [Additional Reference(s): USACE San Joaquin O&M Manual, Unit No. 613, Part C, May 1963, Revised 15 April 2010, (Station 93+00), 24-inch pipe listed. USACE As-Built File No. CA-2-6-147, Sheet No. 147/22, 25 March 1954, (Station 93+00)]. FS Date: 4/28/2021

Levee crown looking upstream.

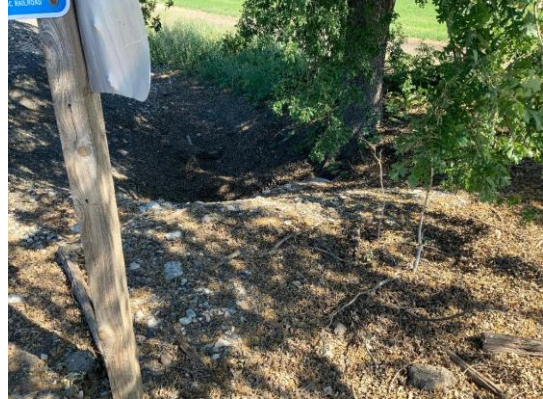
Photo 2 of 3 : UCIP_FA_2023_78254_97052.jpg

LS view: Toe from crown.

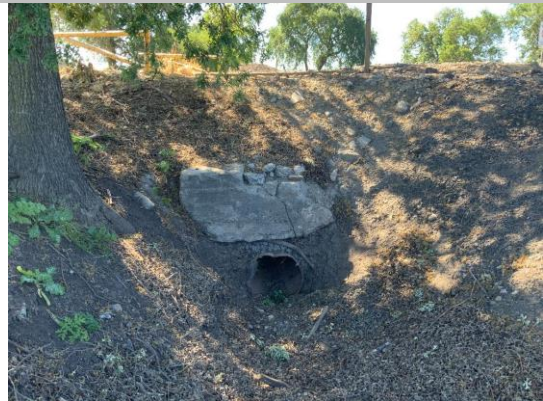
Photo 3 of 3 : UCIP_FA_2023_78254_97053.jpg

LS view: Slope and pipe inlet at toe.

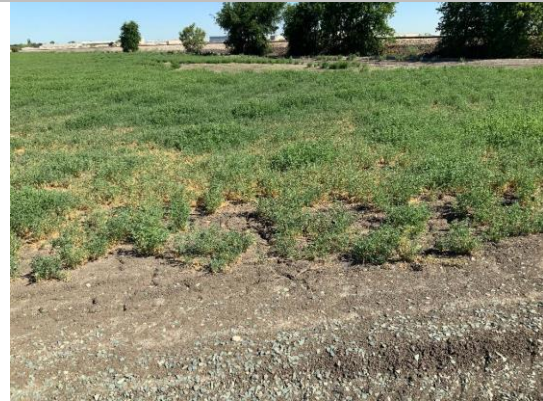
Photo 1 of 3 : UCIP_FA_2023_78255_97076.jpg

Comment Code					
Inspector Comment					
DS_ID:17980 FS_ID:78255 EP_NO: N/A Repair Type: Non-Urgent EVAL Issue: Crossing Status: Not Found UCIP Comments: 04/28/2021 Record has been upgraded from No Action Needed to Non-Urgent. Unit 2 – Littlejohn Creek (CLM 1.20 to 1.70) is considered a patrol road/high ground area with no defined levee prism, any issue found between CLM 1.20-1.70 of Unit 2 will be considered a maintenance issue, or an unauthorized encroachment, or an abandoned encroachment. Pipe not found by visual inspection. No permit was found authorizing this encroachment. CVFPB will need to review crossing to determine owner. The UCIP inspection was completed with LMA representative, J. Nelson. (H. Dunn – GEI) FIELD_STRUCT_DESC: 12-inch corrugated metal gravity drainage pipe (CMP) through the levee, 7.0 feet below the crown. Flap gate on the waterside (WS) end. [Additional Reference(s): DWR Levee Log, 1977, (HLM 1.52). USACE San Joaquin O&M Manual, Unit No. 613, Part C, May 1963, Revised 15 April 2010, (Station 91+80), 12-inch pipe listed. USACE As-Built Drawing No. CA-2-6-147, Sheets 22 and 24, STA 91+80, 27 June 1955]. FS Date: 4/28/2021

LS view: Toe from crown, no pipe visible.

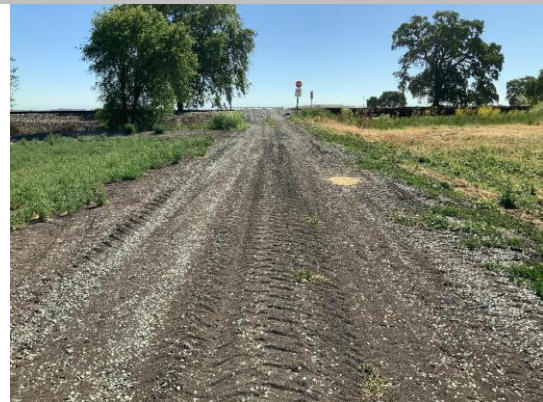
Photo 2 of 3 : UCIP_FA_2023_78255_97077.jpg

Levee crown looking upstream.
