**Flood Control Project Maintenance
Levee Inspections**

Maintenance Issue Types Only, Levee Inspection Report By Mile - Fall 2023

San Joaquin County Flood Control and Water Conservation District

Waterway	Bank	Unit Miles	Inspection Start/End	Inspector
Unit No. 01 Littlejohn Creek	Left	2.59	10/20/2023 10/20/2023	Alberto De Leon

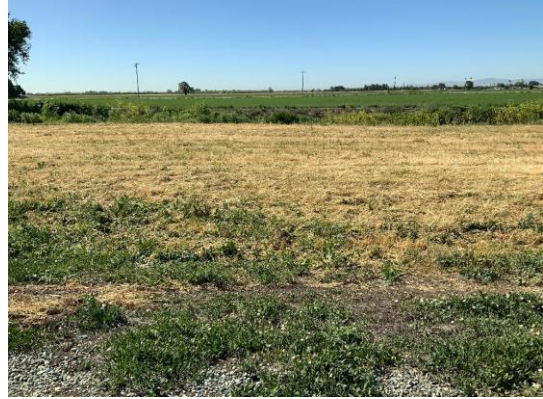
Photo 3 of 3 : UCIP_FA_2023_78255_97078.jpg

Comment Code					
Inspector Comment					
DS_ID:17980 FS_ID:78255 EP_NO: N/A Repair Type: Non-Urgent EVAL Issue: Crossing Status: Not Found UCIP Comments: 04/28/2021 Record has been upgraded from No Action Needed to Non-Urgent. Unit 2 – Littlejohn Creek (CLM 1.20 to 1.70) is considered a patrol road/high ground area with no defined levee prism, any issue found between CLM 1.20-1.70 of Unit 2 will be considered a maintenance issue, or an unauthorized encroachment, or an abandoned encroachment. Pipe not found by visual inspection. No permit was found authorizing this encroachment. CVFPB will need to review crossing to determine owner. The UCIP inspection was completed with LMA representative, J. Nelson. (H. Dunn – GEI) FIELD_STRUCT_DESC: 12-inch corrugated metal gravity drainage pipe (CMP) through the levee, 7.0 feet below the crown. Flap gate on the waterside (WS) end. [Additional Reference(s): DWR Levee Log, 1977, (HLM 1.52). USACE San Joaquin O&M Manual, Unit No. 613, Part C, May 1963, Revised 15 April 2010, (Station 91+80), 12-inch pipe listed. USACE As-Built Drawing No. CA-2-6-147, Sheets 22 and 24, STA 91+80, 27 June 1955]. FS Date: 4/28/2021

WS view: Toe from crown, no pipe visible.

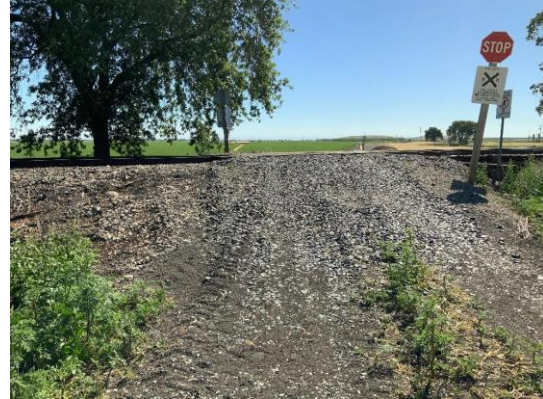
Photo 1 of 3 : UCIP_FA_2023_78233_97062.jpg

Comment Code						
Inspector Comment						
DS_ID:23998 FS_ID:78233 EP_NO: N/A Repair Type: Non-Urgent EVAL Issue: 11, Maintenance Compliance Issue Crossing Status: Found UCIP Comments: 01/03/2023 DMP field confirmed the diameter of the pipe being 15 inches. Field structure description has been updated. (O.Yakimov - DWR UCIP) 04/28/2021 Record has been upgraded from No Action Needed to Non-Urgent. Unit 2 – Littlejohn Creek (CLM 1.20 to 1.70) is considered a patrol road/high ground area with no defined levee prism, any issue found between CLM 1.20-1.70 of Unit 2 will be considered a maintenance issue, or an unauthorized encroachment, or an abandoned encroachment. DWR DMP internal video inspection has found pipe integrity issues. LOF of crossing is between 4.1 and 5. Crossing will be monitored until funding becomes available for rehabilitation. Current condition of pipe crossing does not impede access to patrol road/high ground area. No permit was found authorizing this encroachment. CVFPB will need to review crossing to determine owner. The UCIP inspection was completed with LMA representative, J. Nelson. (H. Dunn – GEI) 11/02/2018 Inlet and outlet cleared of dirt and vegetation by the LMA. This crossing continues to be rated "No Action Needed." (A. McDonald - DWR UCIP)04/02/2014 Galvanized iron plate slide gate on waterside. It is not not a old pipe. The plate gate looks new. (P. Amatya - DWR UCIP) FIELD_STRUCT_DESC: *High Ground* 15-inch high-density polyethylene (HDPE) gravity drainage pipe through the levee, 7.7 feet below the crown. Galvanized iron plate gate on the waterside (WS) end. This crossing is believed to be a replacement of pipe DSID 17980. FS Date: 4/28/2021 2:29:26 PM

Levee crown looking upstream.

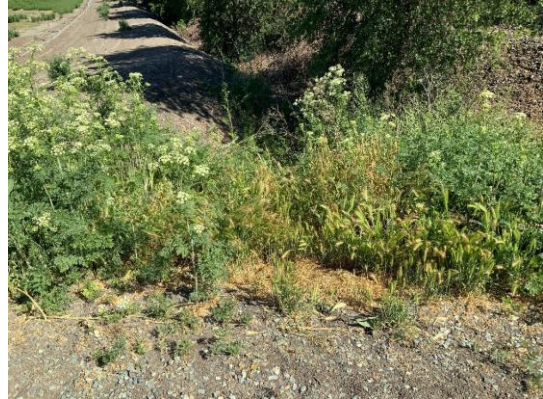
Photo 2 of 3 : UCIP_FA_2023_78233_97066.jpg

LS view: Toe from crown.

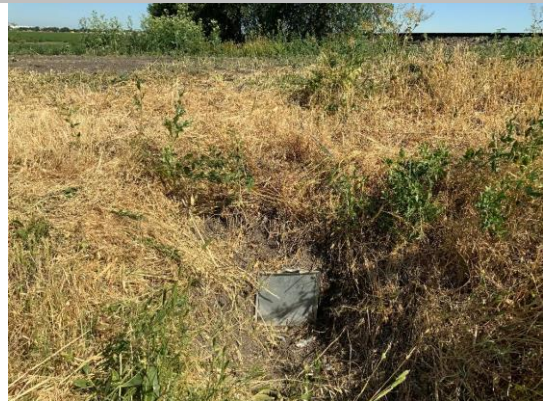
Photo 3 of 3 : UCIP_FA_2023_78233_97063.jpg

WS view: Slope and plate gate at toe.

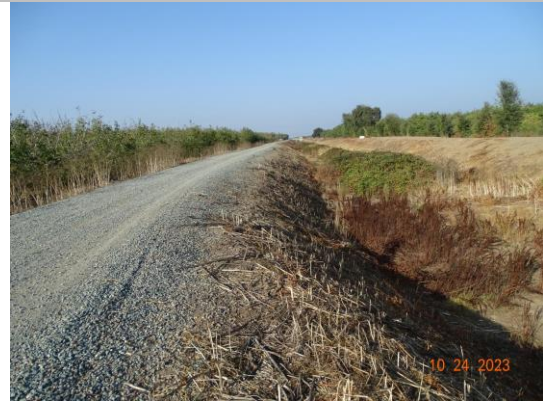
Photo 1 of 1 : FA_2023_NA0017_150_3_20231026_00005.jpg

LM Start	0.23	Rating **	A	Issue No.	3
LM End	0.46	Issue Type +	Ma	Location *	WS
Category	Earthen Levee			GPS Latitude/Longitude	
				Start	End
Item	Vegetation			37.979216°	37.979317°
				-121.094611°	-121.090433°
DWR ID	DWR_NA0017_06_f_2023_3				
Comment Code					
V1 : Control annual grass and weeds on the levee slopes and easements.					
Inspector Comment

Typical view of well maintained vegetation along the waterside slope.
Fall 2023

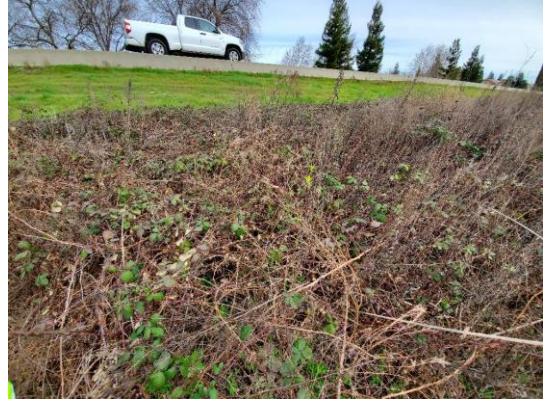
Photo 1 of 3 : UCIP_FA_2023_78858_95618.jpg

Comment Code						
Inspector Comment						
DS_ID:23620 FS_ID:78858 EP_NO: N/A Repair Type: Non-Urgent EVAL Issue: Crossing Status: Not Found UCIP Comments: 02/16/2021 The record has been upgraded from No Action Needed to Non-Urgent. Pipe was not found at the indicated location or surrounding. Dense vegetation at WS toe limited inspection, but no indication of an existing pipe at LS toe with high visibility. DWR DMP geophysical results did not confirm presence of pipe through levee. Record will remain in UCIP's inspection records until future Levee Improvement Project can confirm no crossing was found through the levee. The UCIP inspection was completed with GEI staff, H. Dunn and LMA representative, M. Mccoy. (B. Singh – GEI) FIELD_STRUCT_DESC: 24-inch corrugated metal drainage pipe (CMP) through the levee, 8.8 feet below the crown. Flap gate on the waterside (WS) end. Concrete U-shaped headwall on the WS end. Cobble grouted outlet across the berm. [Additional Reference(s): DWR Levee Log, 1976, (HLM 0.67). USACE San Joaquin O&M Manual 612.1, June 1965, (HLM 0.67), 24-inch pipe listed]. FS Date: 2/16/2021

WS view: WS slope from WS toe. Dense vegetation limiting view.

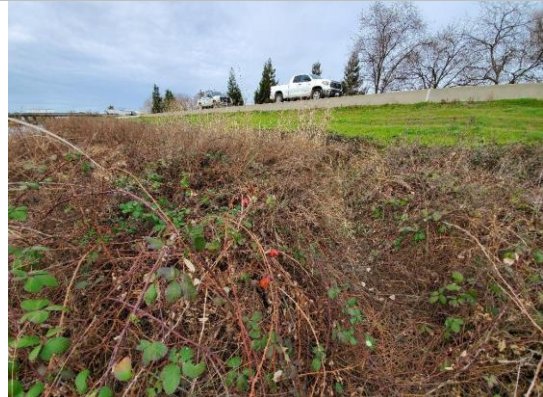
Photo 2 of 3 : UCIP_FA_2023_78858_95619.jpg

WS view: WS slope from toe approximately 30 yards US of indicated location.

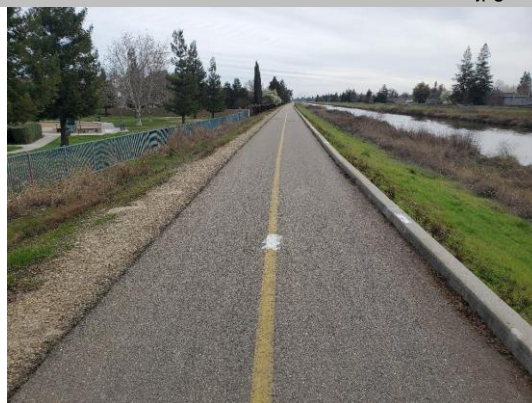
Photo 3 of 3 : UCIP_FA_2023_78858_95620.jpg

Overview of levee crown at indicated location, looking US

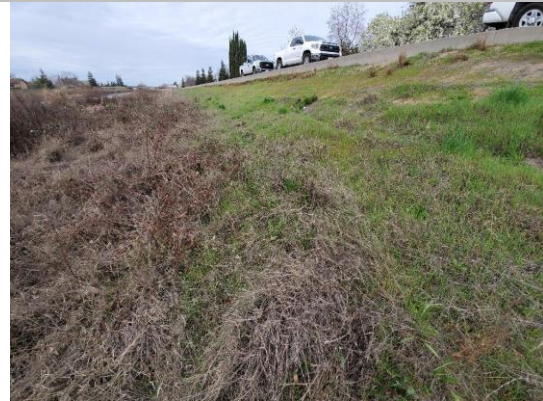
Photo 1 of 3 : UCIP_FA_2023_78859_95644.jpg

Comment Code						
Inspector Comment						
DS_ID:23514 FS_ID:78859 EP_NO: N/A Repair Type: Non-Urgent EVAL Issue: Crossing Status: Not Found UCIP Comments: 02/16/2021 The record has been upgraded from No Action Needed to Non-Urgent. Pipe listed in USACE O&M Manual but was not found in the field. DWR DMP geophysical results did not confirm presence of pipe through levee. Record will remain in UCIP's inspection records until future Levee Improvement Project can confirm no crossing was found through the levee. The UCIP inspection was completed with GEI staff, H. Dunn and LMA representative, M. Mccoy. (B. Singh – GEI) FIELD_STRUCT_DESC: 24-inch corrugated metal drainage pipe (CMP) through the levee, 8.4 feet below the crown. Flap gate on the waterside (WS) end. Concrete U-shaped headwall on the WS end. Cobble grouted outlet across the berm. [Additional Reference(s): DWR Levee Log, 1987, (HLM 0.81). USACE San Joaquin O&M Manual 612.1, June 1965, (HLM 0.81), 24-inch pipe listed]. FS Date: 2/16/2021

WS view: View DS from WS toe

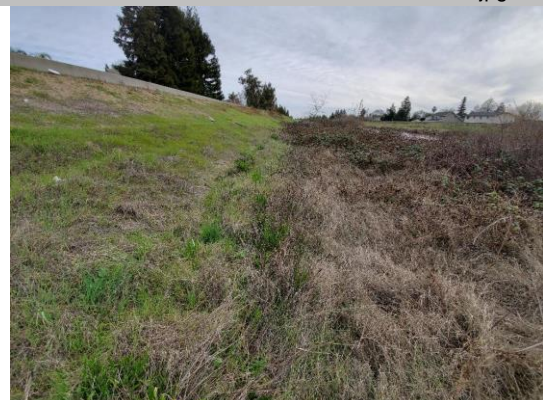
Photo 2 of 3 : UCIP_FA_2023_78859_95645.jpg

WS view: View US from WS toe

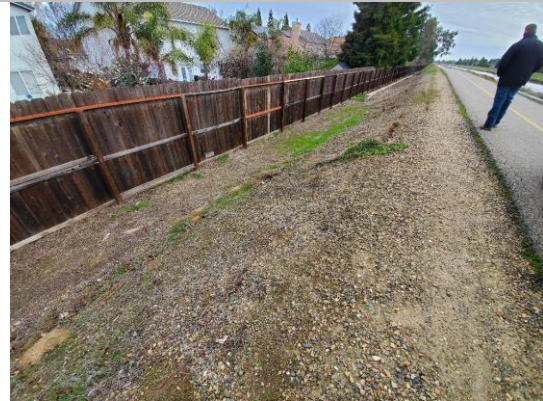
Photo 3 of 3 : UCIP_FA_2023_78859_95646.jpg

LS view: View toward LS toe, looking US

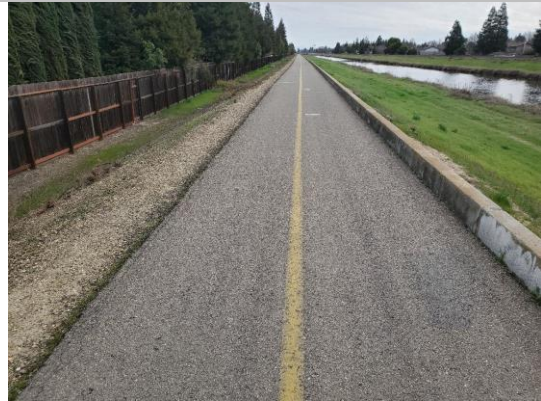
Photo 1 of 3 : UCIP_FA_2023_78860_95685.jpg

Comment Code						
Inspector Comment						
DS_ID:23515 FS_ID:78860 EP_NO: N/A Repair Type: Non-Urgent EVAL Issue: Crossing Status: Not Found UCIP Comments: 02/16/2021 The record has been upgraded from No Action Needed to Non-Urgent. Pipe was not found at indicated or surrounding locations in the field. DWR DMP geophysical results did not confirm presence of pipe through levee. Record will remain in UCIP's inspection records until future Levee Improvement Project can confirm no crossing was found through the levee. The UCIP inspection was completed with GEI staff, H. Dunn and LMA representative, M. Mccoy. (B. Singh – GEI) FIELD_STRUCT_DESC: 24-inch corrugated metal drainage pipe (CMP) through the levee, 8.1 feet below the crown. Flap gate on the waterside (WS) end. Concrete U-shaped headwall on the WS end. Cobble grouted outlet across the berm. [Additional Reference(s): DWR Levee Log, 1987, (HLM 0.94). USACE San Joaquin O&M Manual 612.1, June 1965, (HLM 0.94), 24-inch pipe listed]. FS Date: 2/16/2021

Overview of levee crown, looking US

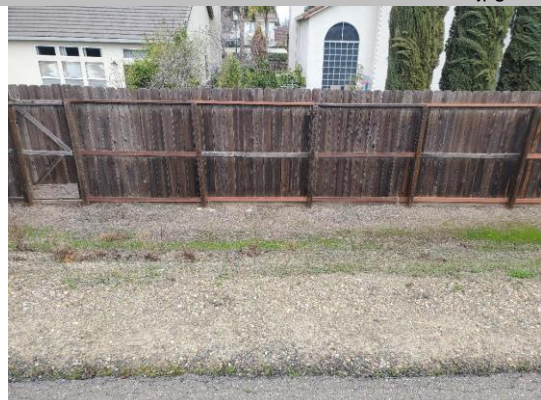
Photo 2 of 3 : UCIP_FA_2023_78860_95686.jpg

LS view: View toward LS toe from levee crown

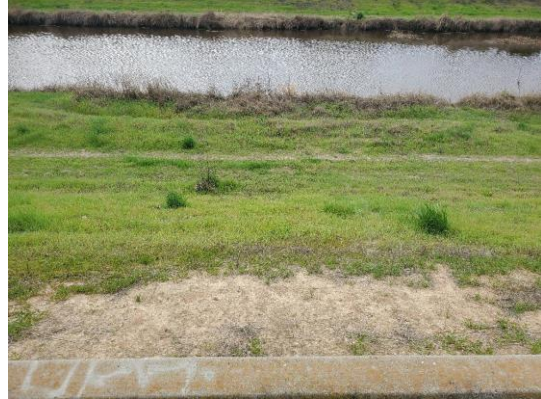
Photo 3 of 3 : UCIP_FA_2023_78860_95687.jpg

WS view: View toward WS toe from levee crown

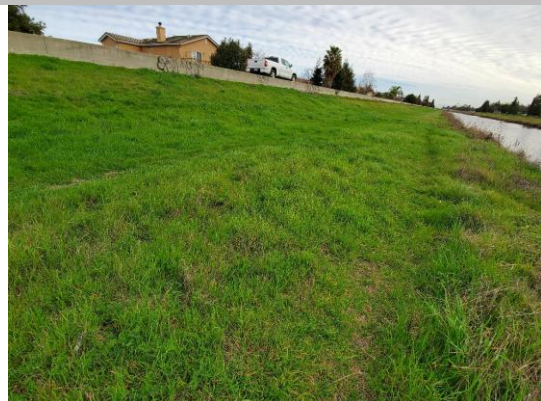
Photo 1 of 3 : UCIP_FA_2023_78861_95693.jpg

DS_ID:23516
 FS_ID:78861
 EP_NO: N/A
 Repair Type: Non-Urgent
 EVAL Issue:
 Crossing Status: Not Found
 UCIP Comments: 02/16/2021 The record has been upgraded from No Action Needed to Non-Urgent. Pipe was not found at indicated or surrounding locations in the field. DWR DMP geophysical results did not confirm presence of pipe through levee. Record will remain in UCIP's inspection records until future Levee Improvement Project can confirm no crossing was found through the levee. The UCIP inspection was completed with GEI staff, H. Dunn and LMA representative, M. McCoy. (B. Singh – GEI)
 FIELD_STRUCT_DESC: 24-inch corrugated metal drainage pipe (CMP) through the levee, 7.4 feet below the crown. Flap gate on the waterside (WS) end. Concrete U-shaped headwall on the WS end. Cobble grouted outlet across the berm. [Additional Reference(s): DWR Levee Log, 1987, (HLM 1.08). USACE San Joaquin O&M Manual 612.1, June 1965, (HLM 1.08), 24-inch pipe listed].

WS view: View US along WS toe

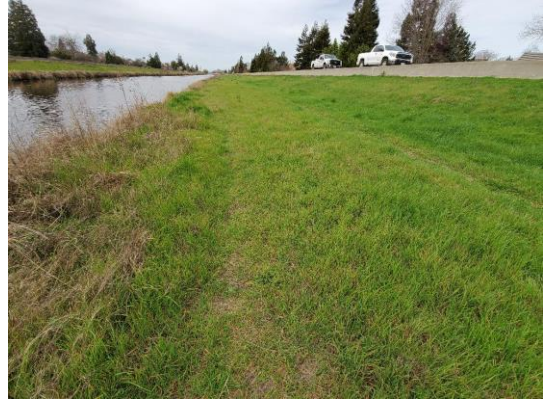
Photo 2 of 3 : UCIP_FA_2023_78861_95694.jpg

WS view: View DS along WS toe

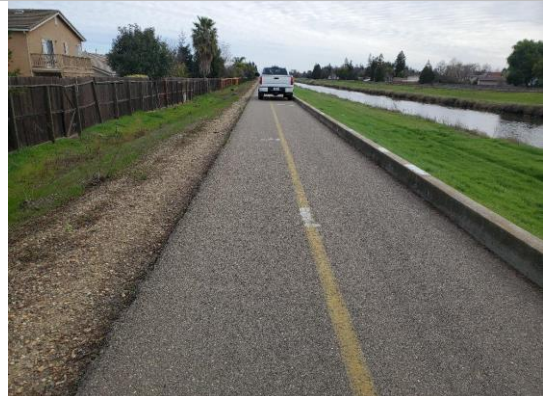
Photo 3 of 3 : UCIP_FA_2023_78861_95695.jpg

Overview of levee crown, looking US

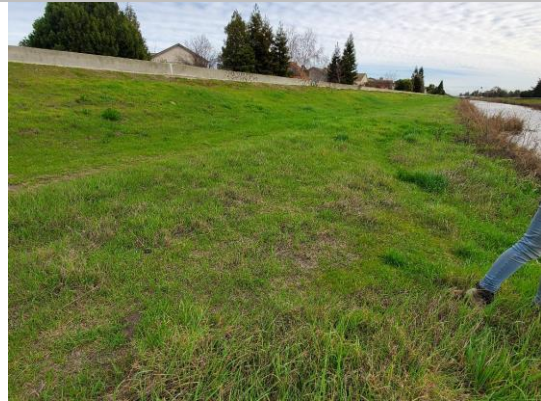
Photo 1 of 3 : UCIP_FA_2023_78862_95702.jpg

Comment Code						
Inspector Comment						
DS_ID:23517 FS_ID:78862 EP_NO: N/A Repair Type: Non-Urgent EVAL Issue: Crossing Status: Indicator Found UCIP Comments: 02/16/2021 The record has been upgraded from No Action Needed to Non-Urgent. Pipe was not found at indicated or surrounding locations in the field. DWR DMP Geophysical study indicates possible presence of pipe through levee. Owner needs to coordinate with the CVFPB to remove or abandon crossing according to Title 23 requirements. Record will remain in UCIP's database and site should be monitored for integrity issues that might arise with buried pipe. No permit was found authorizing this encroachment. CVFPB will need to review crossing to determine owner. The UCIP inspection was completed with GEI staff, H. Dunn and LMA representative, M. McCoy. (B. Singh – GEI) FIELD_STRUCT_DESC: 24-inch corrugated metal drainage pipe (CMP) through the levee, 7.2 feet below the crown. Flap gate on the waterside (WS) end. Concrete U-shaped headwall on the WS end. Cobble grouted outlet across the berm. [Additional Reference(s): DWR Levee Log, 1987, (HLM 1.22). USACE San Joaquin O&M Manual 612.1, June 1965, (HLM 1.22), 24-inch pipe listed]. FS Date: 2/16/2021

WS view: View US along WS toe

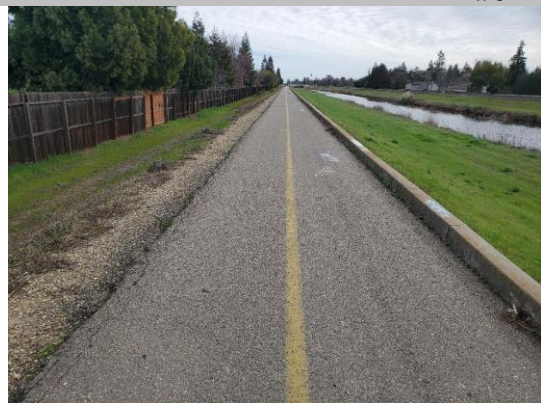
Photo 2 of 3 : UCIP_FA_2023_78862_95703.jpg

Overview of levee crown, looking US

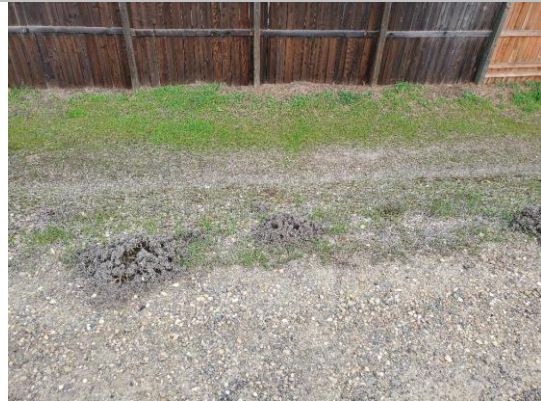
Photo 3 of 3 : UCIP_FA_2023_78862_95704.jpg

LS view: View toward LS toe from levee crown

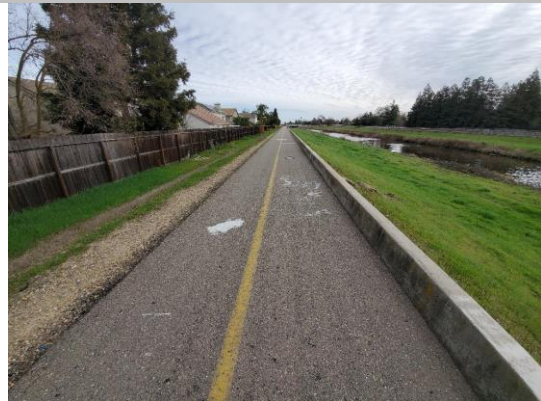
Photo 1 of 3 : UCIP_FA_2023_78863_95711.jpg

DS_ID:23518
 FS_ID:78863
 EP_NO: N/A
 Repair Type: Non-Urgent
 EVAL Issue:
 Crossing Status: Indicator Found
 UCIP Comments: 02/16/2021 The record has been upgraded from No Action Needed to Non-Urgent. Pipe was not found at indicated or surrounding locations in the field. DWR DMP Geophysical study indicates possible presence of pipe through levee. Owner needs to coordinate with the CVFPB to remove or abandon crossing according to Title 23 requirements. Updated coordinates are 38.0432064, -121.3530273. CVFPB will need to review crossing to determine owner. The UCIP inspection was completed with GEI staff, H. Dunn and LMA representative, M. McCoy. (B. Singh ? GEI)
 FIELD_STRUCT_DESC: 24-inch corrugated metal drainage pipe (CMP) through the levee, 7.1 feet below the crown. Flap gate on the waterside (WS) end. Concrete U-shaped headwall on the WS end. Cobble grouted outlet across the berm. [Additional Reference(s): DWR Levee Log, 1987, (HLM 1.36). USACE San Joaquin O&M Manual 612.1, June 1965, (HLM 1.36), 24-inch pipe listed].

Overview of levee crown, looking US

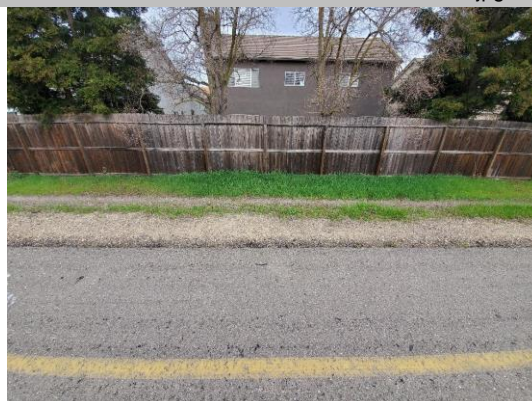
Photo 2 of 3 : UCIP_FA_2023_78863_95712.jpg

LS view: View toward LS toe from levee crown

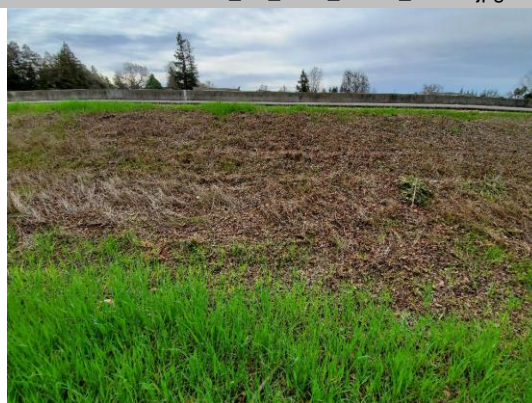
Photo 3 of 3 : UCIP_FA_2023_78863_95713.jpg

LS view: LS slope from LS toe

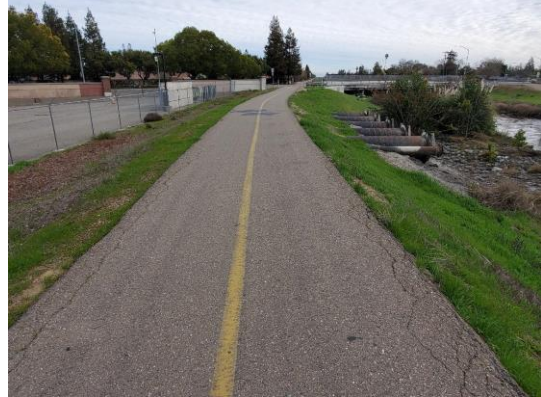
Photo 1 of 3 : UCIP_FA_2023_78263_95727.jpg

Comment Code					
Inspector Comment					
DS_ID:23695 FS_ID:78263 EP_NO: N/A Repair Type: Non-Urgent EVAL Issue: Crossing Status: Found UCIP Comments: 02/16/2021 The record has been upgraded from No Action Needed to Non-Urgent. No permit was found authorizing this encroachment. CVFPB will need to review crossing to determine owner. The UCIP inspection was completed with GEI staff, H. Dunn and LMA representative, M. McCoy. (B. Singh – GEI) FIELD_STRUCT_DESC: [Thornton Road Pump Station] 1 of 6: 12-inch wrapped steel storm drainage pipe through the levee, approximately 3.0 feet below the crown. Pump station on the landside (LS). Flap gate on the waterside (WS) end. [Additional Reference(s): USACE San Joaquin O&M Manual 612 (addendum), February 1999, (HLM 2.16), (Station 114+25), 12-inch pipe listed]. FS Date: 2/16/2021

Overview of levee crown, looking US

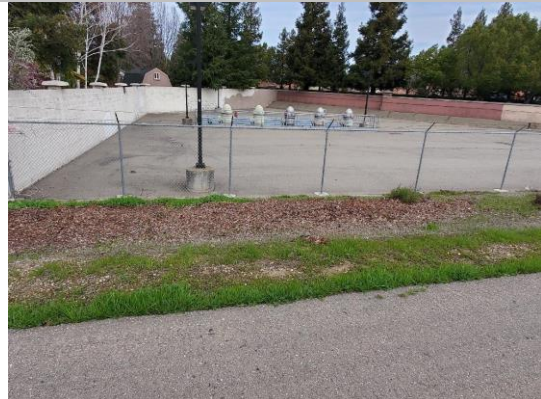
Photo 2 of 3 : UCIP_FA_2023_78263_95728.jpg

LS view: View toward LS toe and pumping plant from levee crown

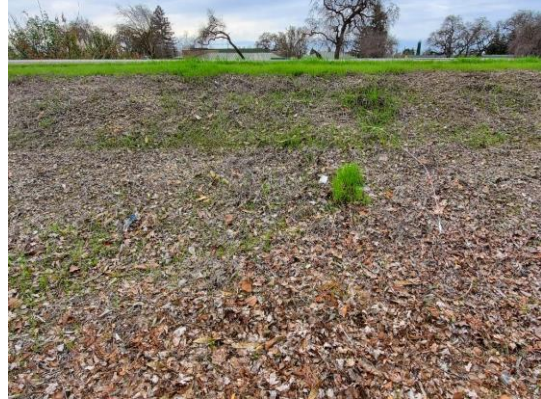
Photo 3 of 3 : UCIP_FA_2023_78263_95729.jpg

LS view: LS slope from LS toe

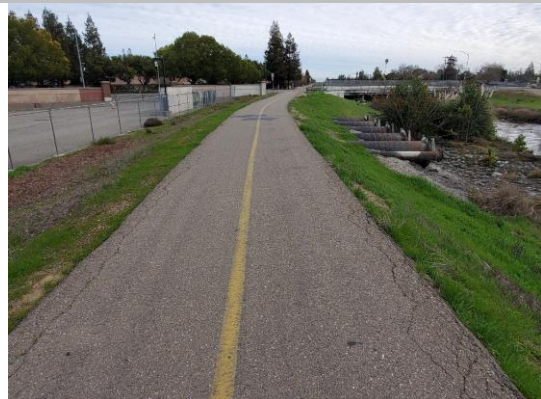
Photo 1 of 3 : UCIP_FA_2023_78264_95733.jpg

DS_ID:23650
 FS_ID:78264
 EP_NO: N/A
 Repair Type: Non-Urgent
 EVAL Issue:
 Crossing Status: Found
 UCIP Comments: 02/16/2021 The record has been upgraded from No Action Needed to Non-Urgent. No permit was found authorizing this encroachment. CVFPB will need to review crossing to determine owner. The UCIP inspection was completed with GEI staff, H. Dunn and LMA representative, M. McCoy. (B. Singh – GEI)
 FIELD_STRUCT_DESC: [Thornton Road Pump Station] 2 of 6: 36-inch wrapped steel storm drainage pipe through the levee, approximately 3.0 feet below the crown. Pump station on the landside (LS). Flap gate on the waterside (WS) end. [Additional Reference(s): USACE San Joaquin O&M Manual 612 (addendum), February 1999, (HLM 2.16), (Station 114+25), 36-inch pipe listed].
 FS Date: 2/16/2021

Overview of levee crown, looking US

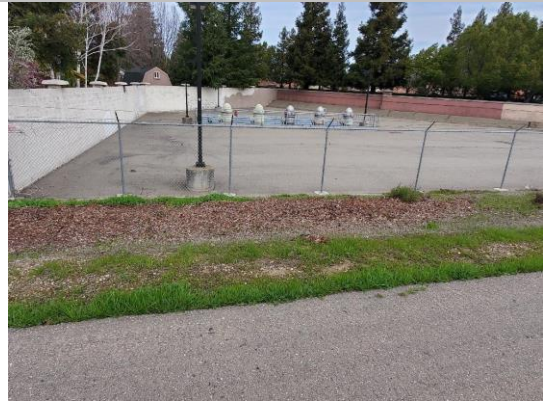
Photo 2 of 3 : UCIP_FA_2023_78264_95734.jpg

LS view: View toward LS toe and pump station from levee crown

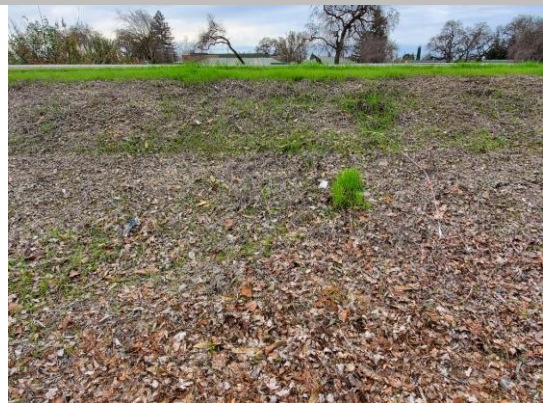
Photo 3 of 3 : UCIP_FA_2023_78264_95735.jpg

LS view: LS slope from LS toe

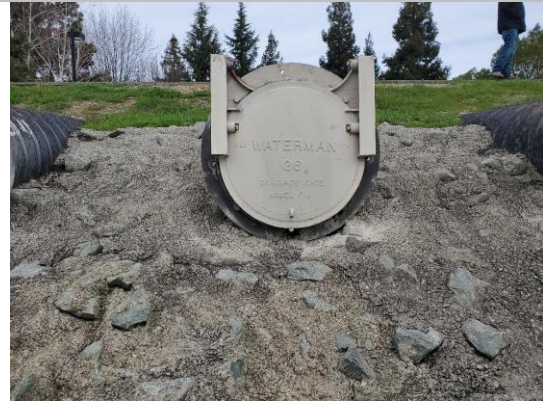
Photo 1 of 3 : UCIP_FA_2023_78265_95739.jpg

Comment Code						
Inspector Comment						
DS_ID:23691 FS_ID:78265 EP_NO: N/A Repair Type: Non-Urgent EVAL Issue: Crossing Status: Found UCIP Comments: 02/16/2021 The record has been upgraded from No Action Needed to Non-Urgent. No permit was found authorizing this encroachment. CVFPB will need to review crossing to determine owner. The UCIP inspection was completed with GEI staff, H. Dunn and LMA representative, M. Mccoy. (B. Singh – GEI) FIELD_STRUCT_DESC: [Thornton Road Pump Station] 3 of 6: 36-inch wrapped steel storm drainage pipe through the levee, approximately 3.0 feet below the crown. Pump station on the landside (LS). Flap gate on the waterside (WS) end. [Additional Reference(s): USACE San Joaquin O&M Manual 612 (addendum), February 1999, (HLM 2.16), (Station 114+25), 36-inch pipe listed]. FS Date: 2/16/2021

WS view: Pipe at WS toe

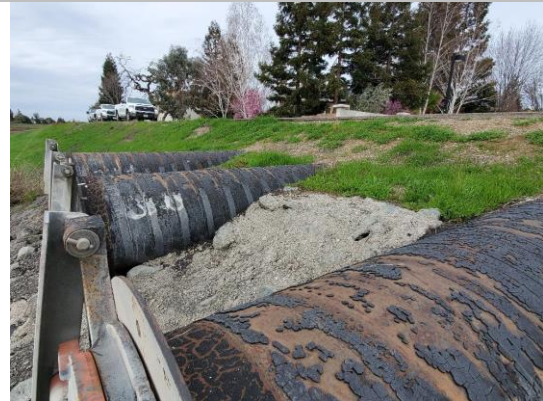
Photo 2 of 3 : UCIP_FA_2023_78265_95740.jpg

WS view: Pipe and WS slope from WS toe

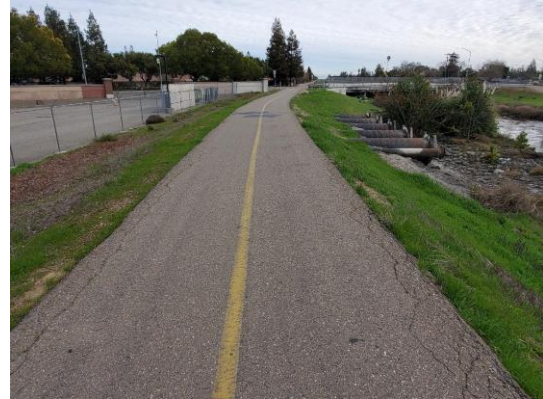
Photo 3 of 3 : UCIP_FA_2023_78265_95741.jpg

Overview of levee crown

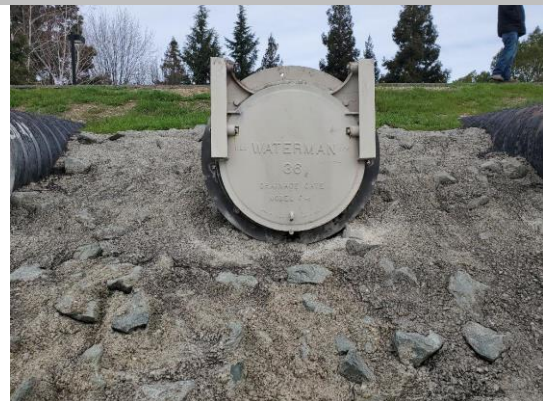
Photo 1 of 3 : UCIP_FA_2023_78266_95745.jpg

DS_ID:23692
 FS_ID:78266
 EP_NO: N/A
 Repair Type: Non-Urgent
 EVAL Issue:
 Crossing Status: Found
 UCIP Comments: 02/16/2021 The record has been upgraded from No Action Needed to Non-Urgent. No permit was found authorizing this encroachment. CVFPB will need to review crossing to determine owner. The UCIP inspection was completed with GEI staff, H. Dunn and LMA representative, M. McCoy. (B. Singh – GEI)
 FIELD_STRUCT_DESC: [Thornton Road Pump Station] 4 of 6: 36-inch wrapped steel storm drainage pipe through the levee, approximately 3.0 feet below the crown. Pump station on the landside (LS). Flap gate on the waterside (WS) end. [Additional Reference(s): USACE San Joaquin O&M Manual 612 (addendum), February 1999, (HLM 2.16), (Station 114+25), 36-inch pipe listed].
 FS Date: 2/16/2021

WS view: Pipe at WS toe

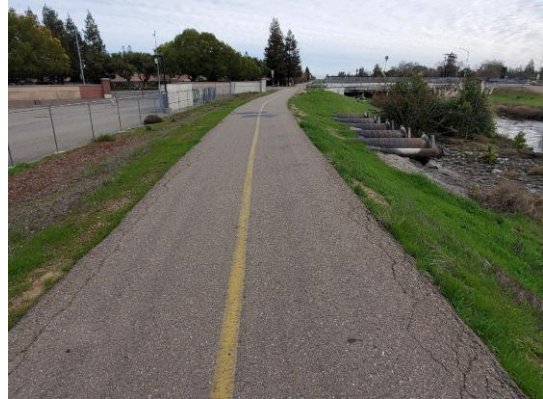
Photo 2 of 3 : UCIP_FA_2023_78266_95746.jpg

Overview of levee crown, looking US

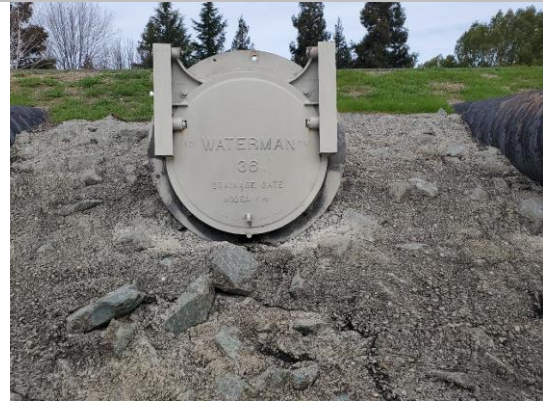
Photo 1 of 3 : UCIP_FA_2023_78267_95749.jpg

Comment Code						
Inspector Comment						
DS_ID:23693 FS_ID:78267 EP_NO: N/A Repair Type: Non-Urgent EVAL Issue: Crossing Status: Found UCIP Comments: 02/16/2021 The record has been upgraded from No Action Needed to Non-Urgent. No permit was found authorizing this encroachment. CVFPB will need to review crossing to determine owner. The UCIP inspection was completed with GEI staff, H. Dunn and LMA representative, M. Mccoy. (B. Singh – GEI) FIELD_STRUCT_DESC: [Thornton Road Pump Station] 5 of 6: 36-inch wrapped steel storm drainage pipe through the levee, approximately 3.0 feet below the crown. Pump station on the landside (LS). Flap gate on the waterside (WS) end. [Additional Reference(s): USACE San Joaquin O&M Manual 612 (addendum), February 1999, (HLM 2.16), (Station 114+25), 36-inch pipe listed]. FS Date: 2/16/2021

WS view: Pipe at WS toe

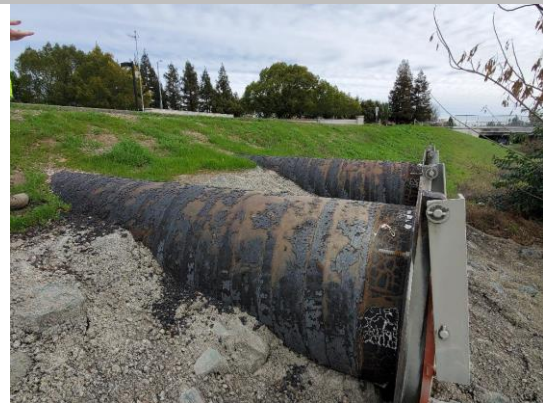
Photo 2 of 3 : UCIP_FA_2023_78267_95750.jpg

WS view: Pipe and slope from WS toe

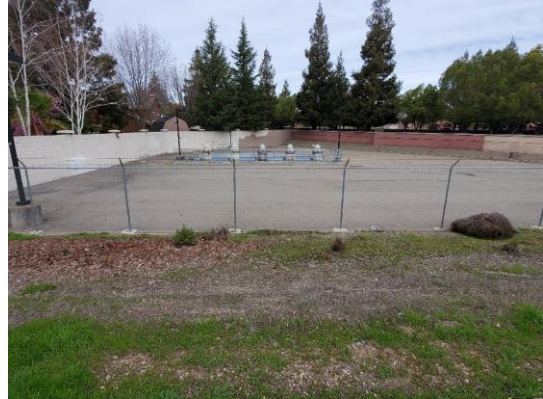
Photo 3 of 3 : UCIP_FA_2023_78267_95751.jpg

LS view: View toward pump station and LS toe from levee crown

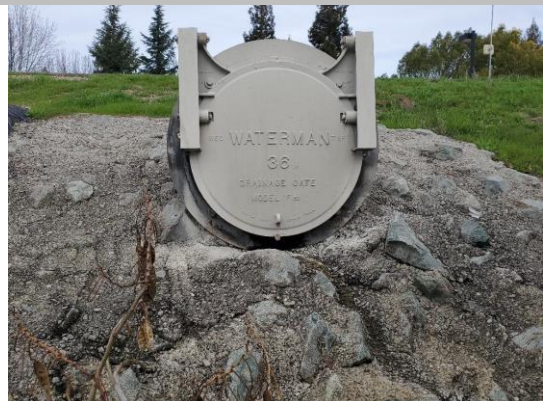
Photo 1 of 3 : UCIP_FA_2023_78268_95755.jpg

DS_ID:23694
 FS_ID:78268
 EP_NO: N/A
 Repair Type: Non-Urgent
 EVAL Issue:
 Crossing Status: Found
 UCIP Comments: 02/16/2021 The record has been upgraded from No Action Needed to Non-Urgent. No permit was found authorizing this encroachment. CVFPB will need to review crossing to determine owner. The UCIP inspection was completed with GEI staff, H. Dunn and LMA representative, M. McCoy. (B. Singh – GEI)
 FIELD_STRUCT_DESC: [Thornton Road Pump Station] 6 of 6: 36-inch wrapped steel storm drainage pipe through the levee, approximately 3.0 feet below the crown. Pump station on the landside (LS). Flap gate on the waterside (WS) end. [Additional Reference(s): USACE San Joaquin O&M Manual 612 (addendum), February 1999, (HLM 2.16), (Station 114+25), 36-inch pipe listed].
 FS Date: 2/16/2021

WS view: Pipe at WS toe

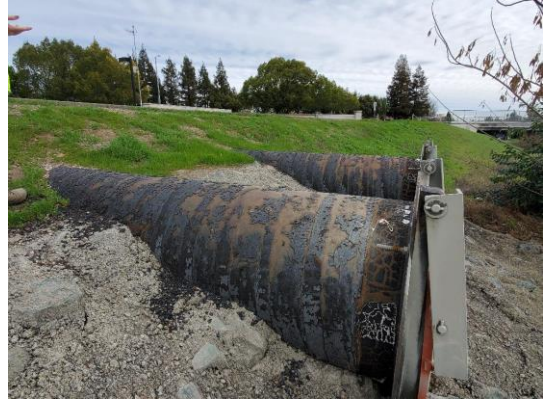
Photo 2 of 3 : UCIP_FA_2023_78268_95756.jpg

WS view: Pipe (right) and WS slope from WS toe

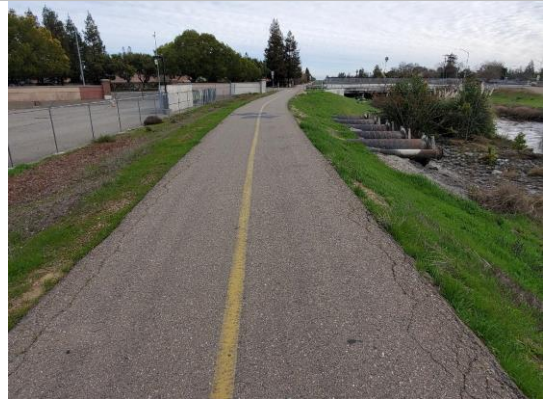
Photo 3 of 3 : UCIP_FA_2023_78268_95757.jpg

Overview of levee crown, looking US

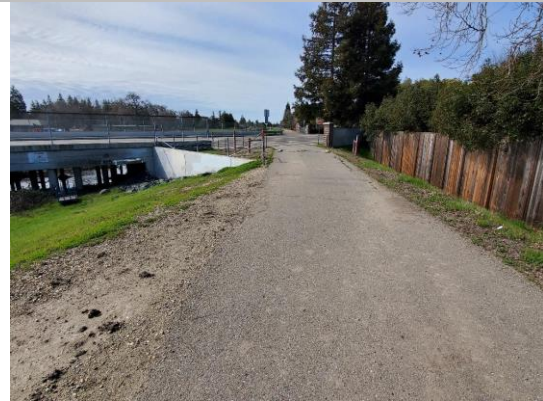
Photo 1 of 2 : UCIP_FA_2023_78865_95778.jpg

Comment Code						
Inspector Comment						
DS_ID:23520 FS_ID:78865 EP_NO: N/A Repair Type: Non-Urgent EVAL Issue: 4b, Safety Issue Crossing Status: Not Found UCIP Comments: 02/16/2021 The record has been upgraded from No Action Needed to Non-Urgent. Inspection was not completed due to housing encampment at site location. Unable to verify presence of crossing. No permit was found authorizing this encroachment. CVFPB will need to review crossing to determine owner. The UCIP inspection was completed with GEI staff, H. Dunn and LMA representative, M. Mccoy. (B. Singh – GEI) FIELD_STRUCT_DESC: 24-inch corrugated metal drainage pipe (CMP) through the levee, 7.6 feet below the crown. Concrete U-shaped headwall on both ends. Flap gate on the waterside (WS) end. Cobble grouted outlet across the berm. [Additional Reference(s): DWR Levee Log, 1987, (HLM 1.63). USACE San Joaquin O&M Manual 612.1, June 1965, (HLM 1.63), 24-inch pipe listed]. FS Date: 2/16/2021

Overview of levee crown, looking DS

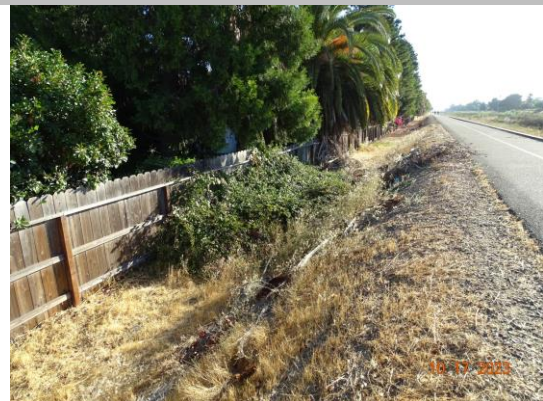
Photo 1 of 1 : FA_2023_NA0017_151_120_20231101_00355.jpg

LM Start	1.79	Rating **	U	Issue No.	120
LM End	1.79	Issue Type +	Ma	Location *	LS
Category	Earthen Levee			GPS Latitude/Longitude	
				Start	End
Item	Vegetation			38.043243°	38.043243°
				-121.340757°	-121.340757°
DWR ID	DWR_NA0017_07_f_2023_120				
Comment Code					
V2 : Remove the wild growth and woody vegetation other than native grasses from the levee slopes.					
Inspector Comment					
Wild berries growing within the landside easement.

View of wild vegetation growth along the landside slope and easement.
Fall 2023

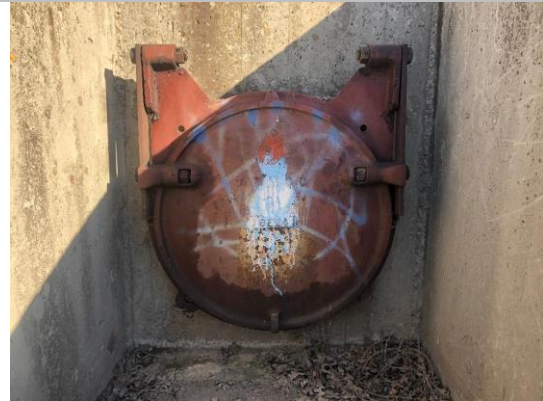
Photo 1 of 3 : UCIP_FA_2023_78866_91080.jpg

Comment Code					
Inspector Comment					
DS_ID:23522 FS_ID:78866 EP_NO: N/A Repair Type: Non-Urgent EVAL Issue: Crossing Status: Found UCIP Comments: 02/17/2021 Record was updated from No Action Needed to Non-Urgent. Upon inspection, LS pipe edges were warped and the coated tar lining deteriorating. DWR DMP internal inspection has not found pipe integrity issues. LOF of crossing is less or equal to 4.0. Recommend next video inspection in 5 years. No permit was found authorizing this encroachment. CVFPB will need to review crossing to determine owner. The UCIP inspection was completed with GEI staff, B. Singh, N. Cholewinski, and LMA representative, J. Caruso. (H. Dunn – GEI) FIELD_STRUCT_DESC: 24-inch corrugated metal drainage pipe (CMP) through the levee, 5.5 feet below the crown. Concrete U-shaped headwalls on both ends. Flap gate on the waterside (WS) end. Cobble grouted outlet across the berm. [Additional Reference(s): DWR Levee Log, 1987, (HLM 2.59). USACE San Joaquin O&M Manual 612.1, June 1965, (HLM 2.59), 24-inch pipe listed]. FS Date: 2/17/2021

WS view: Flapgate on WS toe.

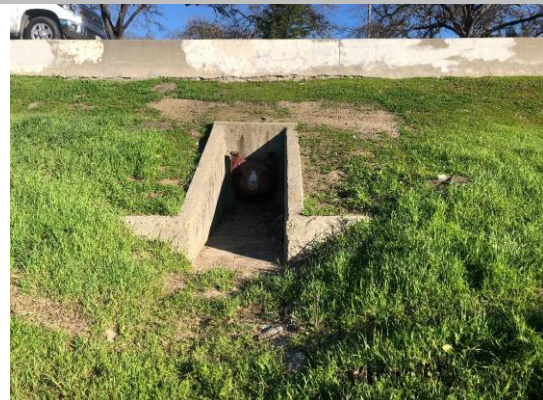
Photo 2 of 3 : UCIP_FA_2023_78866_91081.jpg

WS view: Headwall and flapgate on WS toe.

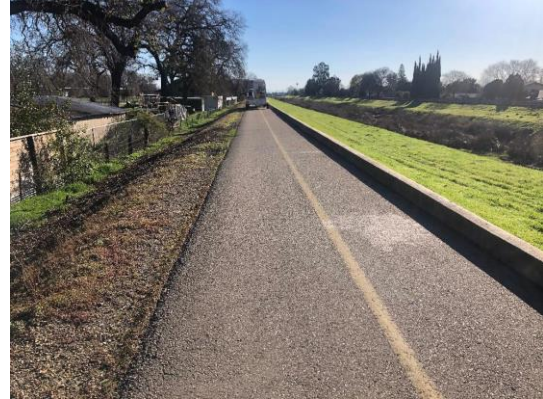
Photo 3 of 3 : UCIP_FA_2023_78866_91082.jpg

Levee crown.

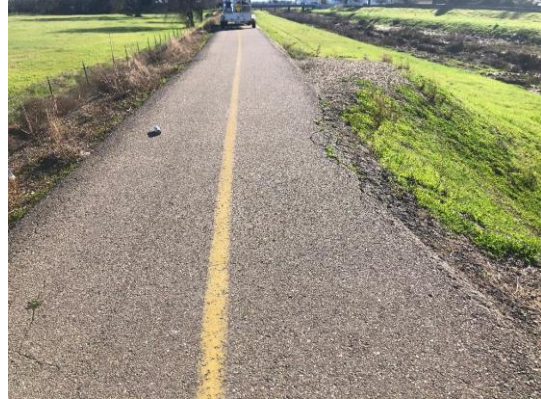
Photo 1 of 3 : UCIP_FA_2023_78937_91085.jpg

Comment Code						
Inspector Comment						
DS_ID:23523						
FS_ID:78937						
EP_NO: N/A						
Repair Type: Non-Urgent						
EVAL Issue:						
Crossing Status: Found						
UCIP Comments: 02/17/2021 Record was updated from No Action Needed to Non-Urgent. DWR DMP has not found internal issues, LOF between 1 and 2. Recommend inspection in 5 years. Barbed wire over the LS toe headwall, could not inspect further. No permit was found authorizing this encroachment. CVFPB will need to review crossing to determine owner. The UCIP inspection was completed with GEI staff, B. Singh, N. Cholewinski, and LMA representative, J. Caruso. (H. Dunn – GEI)						
FIELD_STRUCT_DESC: 24-inch corrugated metal drainage pipe (CMP) through the levee, 10.0 feet below the crown. Concrete U-shaped headwalls on both ends. Flap gate on the waterside (WS) end. Cobble grouted outlet across the berm. [Additional Reference(s): USACE San Joaquin O&M Manual 612.1, June 1965, (HLM 2.82), 24-inch pipe listed].

Levee crown.

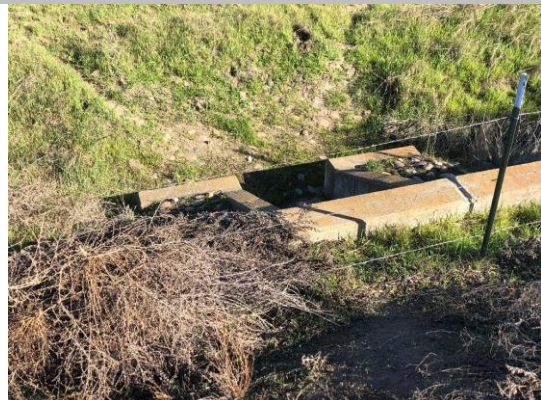
Photo 2 of 3 : UCIP_FA_2023_78937_91086.jpg

LS view: LS headwall from crown. Note barbed wire prevented access to pipe.

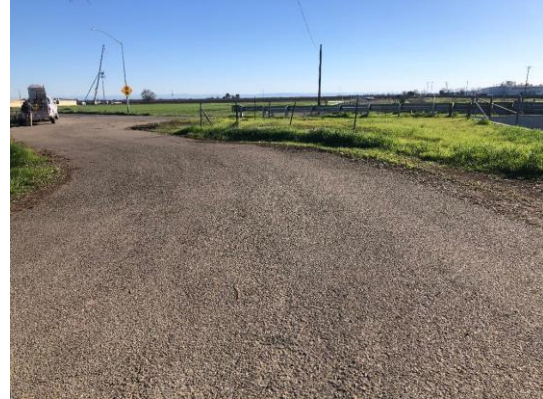
Photo 1 of 3 : UCIP_FA_2023_78868_91140.jpg

Comment Code					
Inspector Comment					
DS_ID:23525 FS_ID:78868 EP_NO: N/A Repair Type: Non-Urgent EVAL Issue: Crossing Status: Found UCIP Comments: 02/17/2021 Record was updated from No Action Needed to Non-Urgent. DWR DMP has not found internal issues, LOF between 1 and 2. Recommend inspection in 5 years. Minor erosion on one edge of the LS headwall. CVFPB will need to review crossing to determine owner. The UCIP inspection was completed with GEI staff, B. Singh, N. Cholewinski, and LMA representative, J. Caruso. (H. Dunn – GEI) FIELD_STRUCT_DESC: 24-inch corrugated metal drainage pipe (CMP) through the levee, 8.0 feet below the crown. Concrete U-shaped headwalls on both ends. Flap gate on the waterside (WS) end. Cobble grouted outlet across the berm. [Additional Reference(s): DWR Levee Log, 1987, (HLM 3.09). USACE San Joaquin O&M Manual 612.1, June 1965, (HLM 3.09), 24-inch pipe listed]. FS Date: 2/17/2021

Levee crown looking upstream.

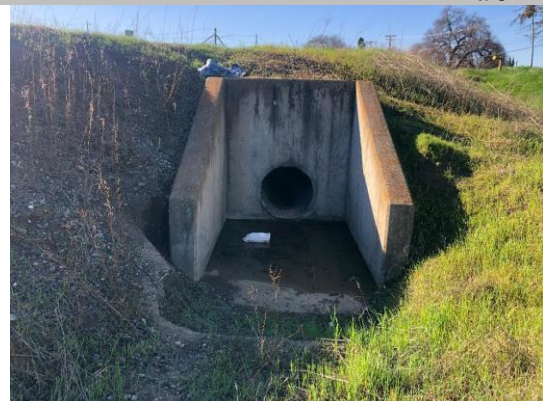
Photo 2 of 3 : UCIP_FA_2023_78868_91141.jpg

LS view: LS headwall at toe. Minor scouring on left side of headwall.

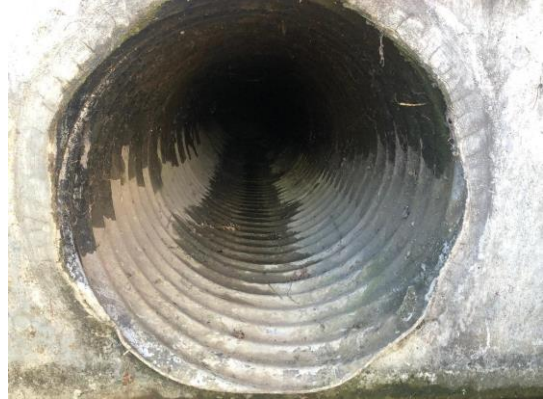
Photo 3 of 3 : UCIP_FA_2023_78868_91142.jpg

LS view: LS pipe.

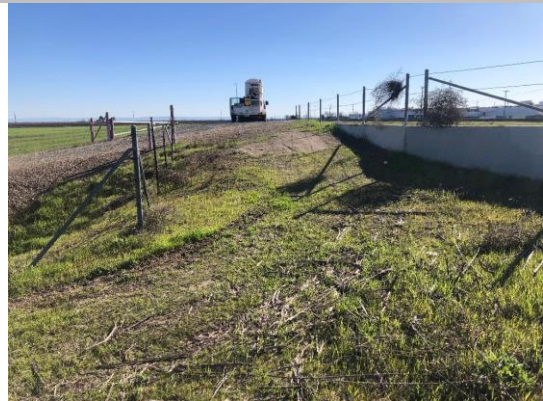
Photo 1 of 3 : UCIP_FA_2023_78869_91156.jpg

DS_ID:23526
 FS_ID:78869
 EP_NO: N/A
 Repair Type: Non-Urgent
 EVAL Issue:
 Crossing Status: Found
 UCIP Comments: 02/17/2021 Record was updated from No Action Needed to Non-Urgent. DWR DMP has not found internal issues, LOF between 1 and 2. Recommend inspection in 5 years. CVFPB will need to review crossing to determine owner. The UCIP inspection was completed with GEI staff, B. Singh, N. Cholewinski, and LMA representative, J. Caruso. (H. Dunn – GEI)
 FIELD_STRUCT_DESC: 24-inch corrugated metal storm drainage pipe (CMP) through the levee, 7.5 feet below the crown. Concrete U-shaped headwalls on both ends. Flap gate on the waterside (WS) end. Cobble grouted outlet across the berm. [Additional Reference(s): DWR Levee Log, 1987, (HLM 3.11). USACE San Joaquin O&M Manual 612.1, June 1965, (HLM 3.12), and 612 (addendum), February 1999, (HLM 3.15), (Station 166+25), 24-inch pipe listed].
 FS Date: 2/17/2021

Levee crown looking upstream.

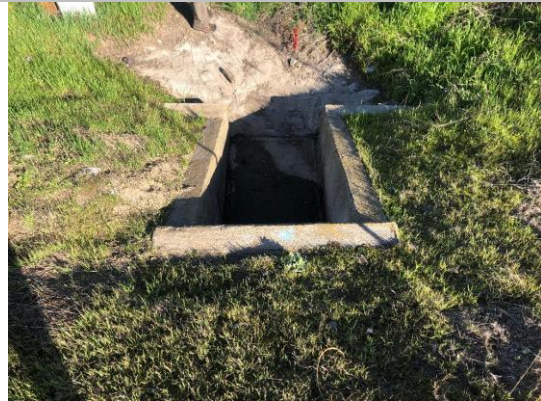
Photo 2 of 3 : UCIP_FA_2023_78869_91157.jpg

LS view: LS headwall at toe from crown.

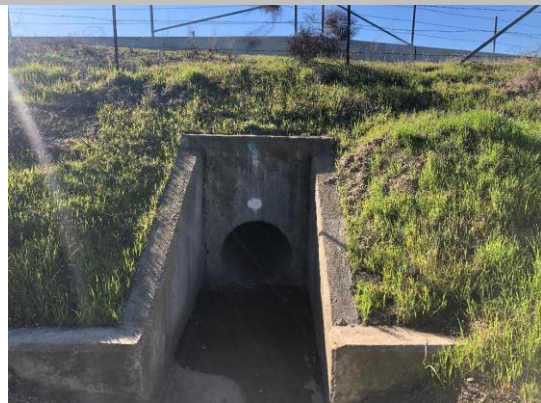
Photo 3 of 3 : UCIP_FA_2023_78869_91158.jpg

LS view: LS headwall at toe.

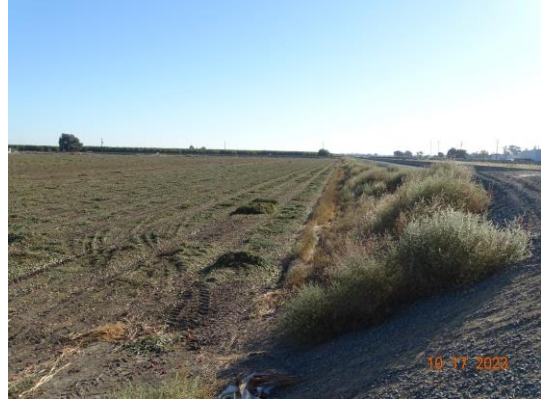
Photo 1 of 1 : FA_2023_NA0017_151_136_20231101_00357.jpg

LM Start	2.84	Rating **	M	Issue No.	136
LM End	3.05	Issue Type +	Ma	Location *	LS
Category	Earthen Levee			GPS Latitude/Longitude	
				Start	End
Item	Vegetation			38.043167°	38.043159°
				-121.321622°	-121.317761°
DWR ID	DWR_NA0017_07_f_2023_136				
Comment Code					
V2 : Remove the wild growth and woody vegetation other than native grasses from the levee slopes.					
Inspector Comment

Typical view of wild vegetation along the landside slope. Fall 2023

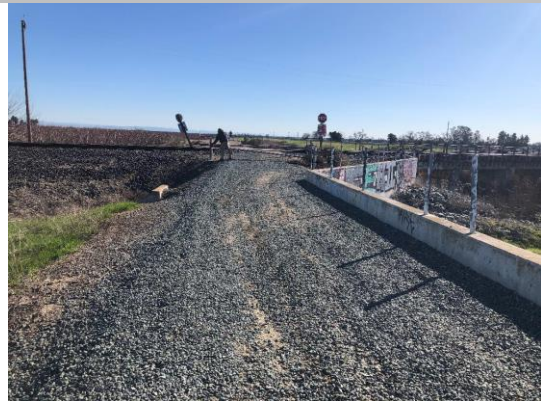
Photo 1 of 3 : UCIP_FA_2023_78870_95478.jpg

Comment Code					
Inspector Comment					
DS_ID:23528					
FS_ID:78870					
EP_NO: N/A					
Repair Type: Non-Urgent					
EVAL Issue:					
Crossing Status: Found					
UCIP Comments: 02/17/2021 Record was updated from No Action					
Needed to Non-Urgent. DWR DMP has not found internal issues, LOF					
between 1 and 2. Recommend inspection in 5 years. CVFPB will need					
to review crossing to determine owner. The UCIP inspection was					
completed with GEI staff, B. Singh, N. Cholewinski, and LMA					
representative, J. Caruso. (H. Dunn – GEI)					
FIELD_STRUCT_DESC: 42-inch corrugated metal drainage pipe (CMP)					
through the levee, 7.3 feet below the crown. Concrete U-shaped					
headwall on both sides. Flap gate on the waterside (WS) end. Grouted					
intake on the landside (LS). Cobble grouted outlet across the berm.					
[Additional Reference(s): DWR Levee Log, 1987, (HLM 3.36). USACE					
San Joaquin O&M Manual 612.1, June 1965, (HLM 3.36), 42-inch pipe

Levee crown looking upstream.

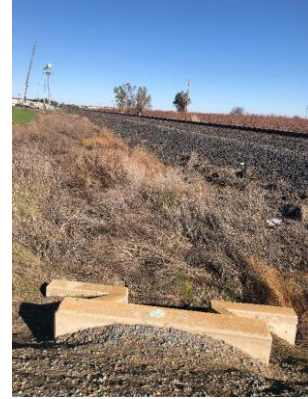
Photo 2 of 3 : UCIP_FA_2023_78870_95479.jpg

LS View: Headwall at toe from crown.

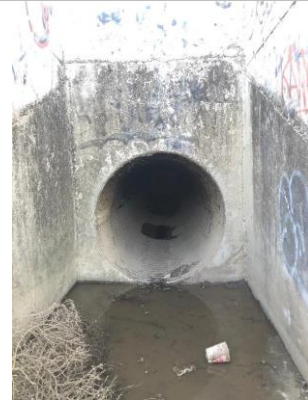
Photo 3 of 3 : UCIP_FA_2023_78870_95480.jpg

LS View: Pipe inlet.

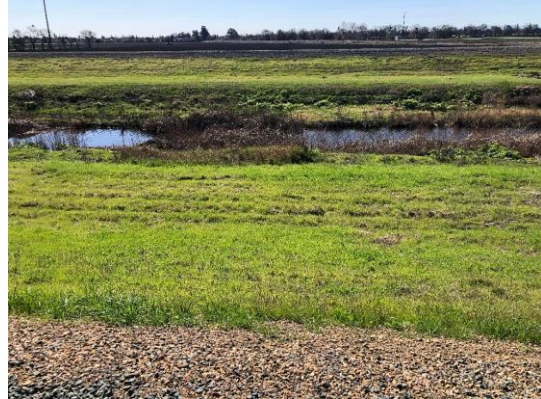
Photo 1 of 3 : UCIP_FA_2023_78278_93643.jpg

Comment Code					
Inspector Comment					
DS_ID:23651 FS_ID:78278 EP_NO: N/A Repair Type: Non-Urgent EVAL Issue: Crossing Status: Not Found UCIP Comments: 02/17/2021 The record has been upgraded from No Action Needed to Non-Urgent. Pipe not found by visual inspection. DWR DMP geophysical study did not confirm presence of pipe through levee. Record will remain in UCIP's inspection records until future Levee Improvement Project can confirm no crossing was found through the levee. No permit was found authorizing this encroachment. CVFPB will need to review crossing to determine owner. The UCIP inspection was completed with GEI staff, B. Singh, N. Cholewinski, and LMA representative, J. Caruso. (H. Dunn – GEI) FIELD_STRUCT_DESC: 24-inch storm drainage pipe of an unknown material through the levee, at an unknown depth. [Additional Reference(s): USACE San Joaquin O&M Manual 612 (addendum), February 1999, (HLM 3.48), (Station 183+50), 24-inch pipe listed]. FS Date: 2/17/2021

WS toe from crown, no pipe visible.

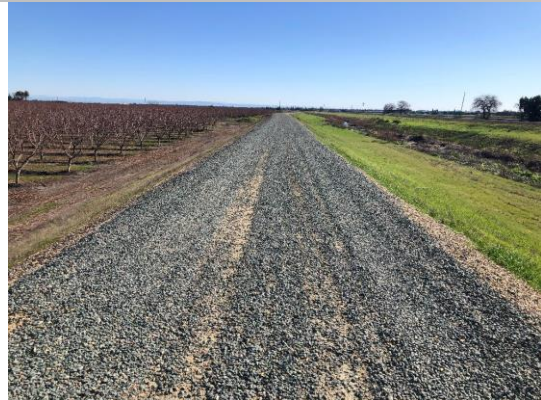
Photo 2 of 3 : UCIP_FA_2023_78278_93644.jpg

Levee crown looking upstream.

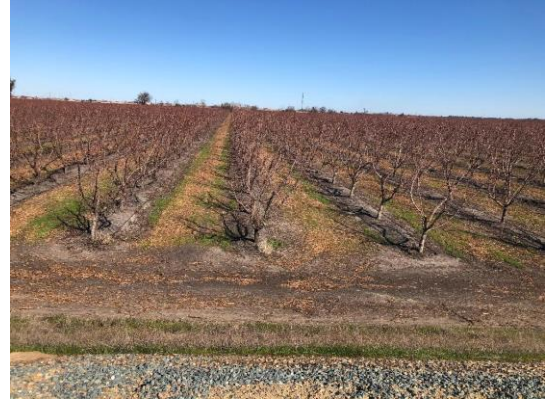
Photo 3 of 3 : UCIP_FA_2023_78278_93645.jpg

LS toe from crown, no pipe visible.

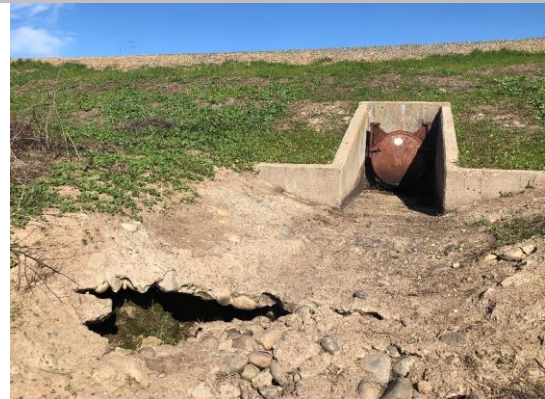
Photo 1 of 3 : UCIP_FA_2023_78940_93666.jpg

DS_ID:23532
 FS_ID:78940
 EP_NO: N/A
 Repair Type: Non-Urgent
 EVAL Issue: 6, Levee Damage or Threat for Levee Damage
 Crossing Status: Found
 UCIP Comments: 09/18/2023 Pipe was CIPP lined. DMP internal video inspection has found none or minor pipe defects. Recommend next video inspection in 5 years. (O. Yakimov - DWR UCIP)
 02/17/2021 The record has been upgraded from No Action Needed to Non-Urgent. DWR DMP has found integrity issues, LOF between 4 and 5. Crossing will be monitored until funding becomes available for rehabilitation. Minor erosion underneath the grouted WS outlet. 2 feet in length, half foot in height. No permit was found authorizing this encroachment. CVFPB will need to review crossing to determine owner. The UCIP inspection was completed with GEI staff, B. Singh, N. Cholewinski, and LMA representative, J. Caruso. (H. Dunn – GEI)
 FIELD_STRUCT_DESC: 36-inch CIPP-lined corrugated metal drainage pipe (CMP) through the levee, 8.5 feet below the crown. Concrete U-shaped headwalls on both ends. Flap gate on the waterside (WS) end. Cobble grouted outlet across the berm. [Additional Reference(s): DWR Levee Log, 1987, (HLM 3.58). USACE San Joaquin O&M Manual 612.1, June 1965, (HLM 3.58), 36-inch pipe listed].

WS headwall and flap gate at toe. Minor erosion underneath cobble grouted outlet.

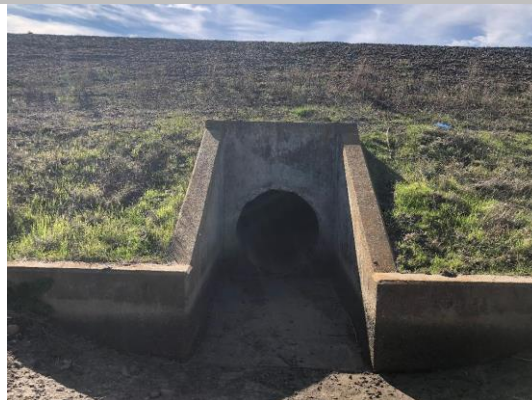
Photo 2 of 3 : UCIP_FA_2023_78940_93662.jpg

LS view: LS headwall at toe.

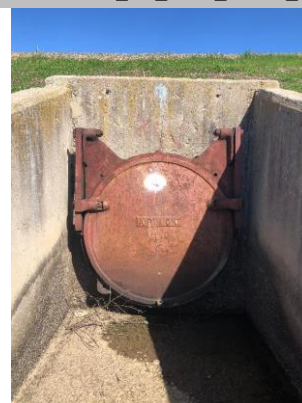
Photo 3 of 3 : UCIP_FA_2023_78940_95505.jpg

WS view: Headwall and close up view of flapgate.

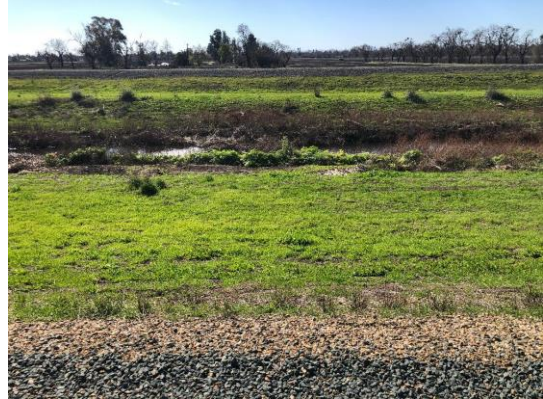
Photo 1 of 3 : UCIP_FA_2023_78281_93668.jpg

Comment Code						
Inspector Comment						
DS_ID:23652 FS_ID:78281 EP_NO: N/A Repair Type: Non-Urgent EVAL Issue: Crossing Status: Not Found UCIP Comments: 02/17/2021 The record has been upgraded from No Action Needed to Non-Urgent. Pipe not found by visual inspection. DWR DMP geophysical study did not confirm presence of pipe through levee. Record will remain in UCIP's inspection records until future Levee Improvement Project can confirm no crossing was found through the levee. No permit was found authorizing this encroachment. CVFPB will need to review crossing to determine owner. The UCIP inspection was completed with GEI staff, B. Singh, N. Cholewinski, and LMA representative, J. Caruso. (H. Dunn – GEI) FIELD_STRUCT_DESC: 24-inch storm drainage pipe of an unknown material through the levee, at an unknown depth. [Additional Reference(s): USACE San Joaquin O&M Manual 612 (addendum), February 1999, (HLM 3.63), (Station 192+15), 24-inch pipe listed]. FS Date: 2/17/2021

WS toe from crown, pipe not visible.

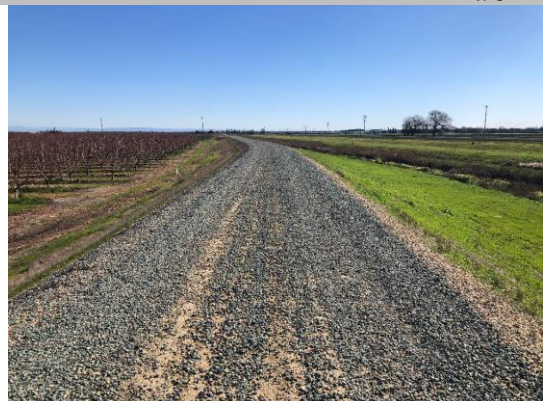
Photo 2 of 3 : UCIP_FA_2023_78281_93669.jpg

Levee crown looking upstream.

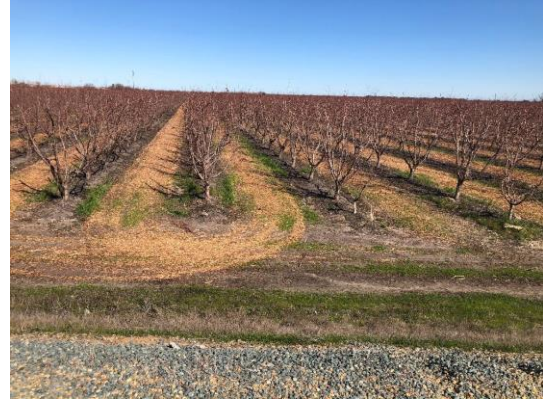
Photo 3 of 3 : UCIP_FA_2023_78281_93670.jpg

LS toe from crown, no pipe visible.
