**Flood Control Project Maintenance
Levee Inspections**

Maintenance Issue Types Only, Levee Inspection Report By Mile - Fall 2023

San Joaquin County Flood Control and Water Conservation District

Waterway	Bank	Unit Miles	Inspection Start/End	Inspector
Unit No. 01 Littlejohn Creek	Left	2.59	10/20/2023 10/20/2023	Alberto De Leon

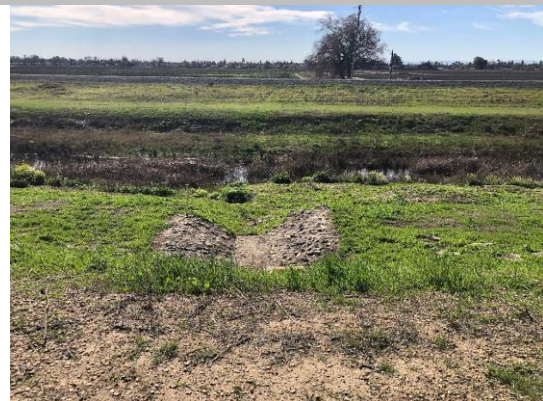
Photo 1 of 3 : UCIP_FA_2023_78941_93682.jpg

DS_ID:23533
 FS_ID:78941
 EP_NO: N/A
 Repair Type: Non-Urgent
 EVAL Issue:
 Crossing Status: Found
 UCIP Comments: 02/17/2021 The record has been upgraded from No Action Needed to Non-Urgent. DWR DMP has not found internal issues, LOF between 1 and 2. Recommend inspection in 5 years. No permit was found authorizing this encroachment. CVFPB will need to review crossing to determine owner. The UCIP inspection was completed with GEI staff, B. Singh, N. Cholewinski, and LMA representative, J. Caruso. (H. Dunn – GEI)
 FIELD_STRUCT_DESC: 24-inch corrugated metal drainage pipe (CMP) through the levee, 7.0 feet below the crown. Concrete U-shaped headwalls on both ends. Flap gate on the waterside (WS) end. Slide gate on the landside (LS) end. Grouted intake on the LS. Cobble grouted outlet across the berm. [Additional Reference(s): DWR Levee Log, 1987, (HLM 3.81). USACE San Joaquin O&M Manual 612.1, June 1965, (HLM 3.81), 24-inch pipe listed].

WS view: WS headwall at toe from crown.

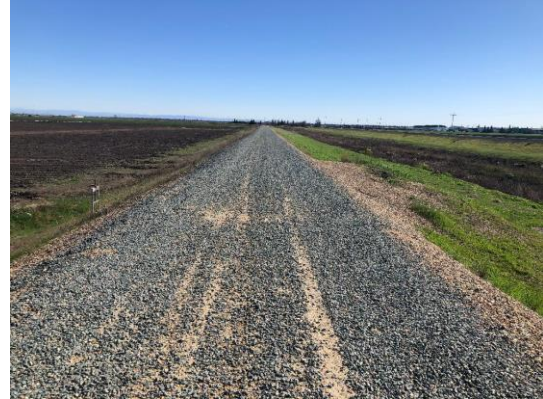
Photo 2 of 3 : UCIP_FA_2023_78941_93684.jpg

Levee crown looking upstream.

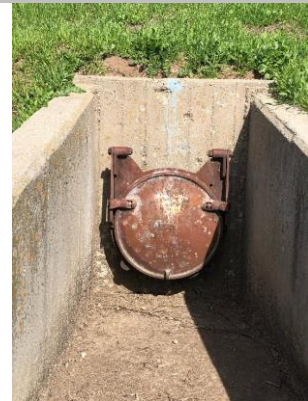
Photo 3 of 3 : UCIP_FA_2023_78941_95513.jpg

WS view: Headwall and close up of flapgate.

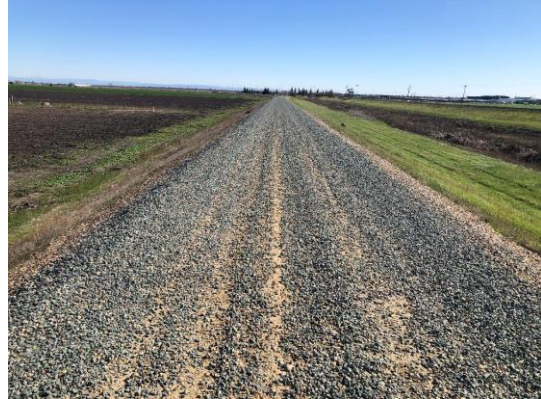
Photo 1 of 3 : UCIP_FA_2023_78284_93689.jpg

Comment Code						
Inspector Comment						
DS_ID:23654 FS_ID:78284 EP_NO: N/A Repair Type: Non-Urgent EVAL Issue: Crossing Status: Not Found UCIP Comments: 02/17/2021 The record has been upgraded from No Action Needed to Non-Urgent. Pipe not found by visual inspection. DWR DMP geophysical study did not confirm presence of pipe through levee. Record will remain in UCIP's inspection records until future Levee Improvement Project can confirm no crossing was found through the levee. No permit was found authorizing this encroachment. CVFPB will need to review crossing to determine owner. The UCIP inspection was completed with GEI staff, B. Singh, N. Cholewinski, and LMA representative, J. Caruso. (H. Dunn – GEI) FIELD_STRUCT_DESC: 42-inch culvert of an unknown material for railroad drainage ditch through the levee, at an unknown depth. [Additional Reference(s): USACE San Joaquin O&M Manual 612 (addendum), February 1999, (HLM 3.90), (Station 206+00), 42-inch pipe listed]. FS Date: 2/17/2021

Levee crown looking upstream.

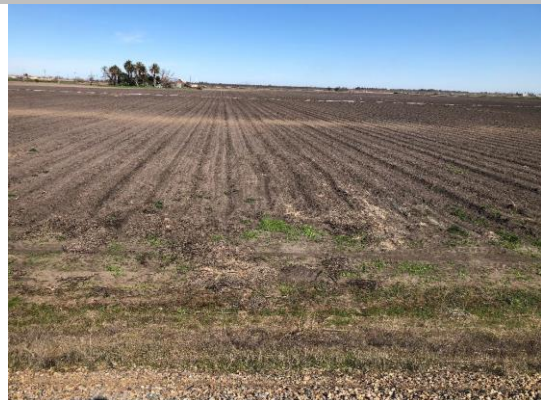
Photo 2 of 3 : UCIP_FA_2023_78284_93690.jpg

LS view: LS toe from crown, no pipe visible.

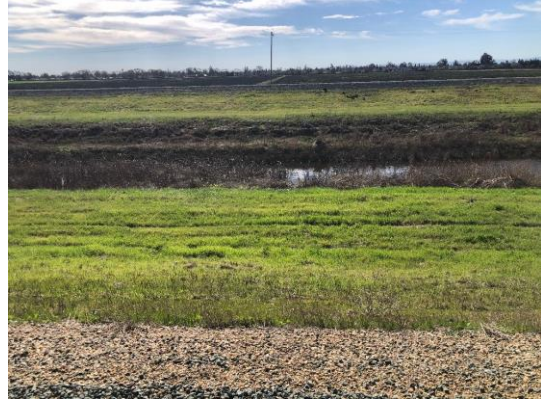
Photo 3 of 3 : UCIP_FA_2023_78284_93691.jpg

WS view: WS toe from crown, no pipe visible.

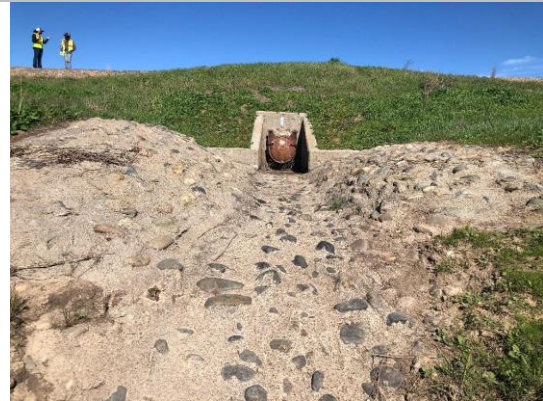
Photo 1 of 3 : UCIP_FA_2023_78874_93717.jpg

Comment Code						
Inspector Comment						
DS_ID:23534 FS_ID:78874 EP_NO: N/A Repair Type: Non-Urgent EVAL Issue: Crossing Status: Found UCIP Comments: 12/20/2022 Record updated from Urgent to Non-Urgent. Pipe has been CIPP lined. LOF of crossing is less or equal to 4. Recommend next video inspection in 5 years. (O.Yakimov - DWR UCIP) 02/17/2021 The record has been upgraded from No Action Needed to Urgent. DWR DMP has found integrity issues, LOF between 5 and 6. Crossing will be monitored until funding becomes available to be addressed. Holes and peeling of metal on the inside bottom of the LS pipe. Recommend LMA create contingency plan for increased inspections during high-water. No permit was found authorizing this encroachment. CVFPB will need to review crossing to determine owner. The UCIP inspection was completed with GEI staff, B. Singh, N. Cholewinski, and LMA representative, J. Caruso. (H. Dunn – GEI) FIELD_STRUCT_DESC: 24-inch CIPP-lined corrugated metal storm drainage pipe (CMP) through the levee, 7.0 feet below the crown. Concrete U-shaped headwalls on both ends. Flap gate on the waterside (WS) end. Slide gate on the landside (LS) end. Grouted intake on the LS. Cobble grouted outlet across the berm. [Additional Reference(s): DWR Levee Log, 1987, (HLM 4.10). USACE San Joaquin O&M Manual 612.1, June 1965, (HLM 4.10), and 612 (addendum), February 1999, (HLM 4.10), (Station 216+43), 24-inch pipe listed]. FS Date: 2/17/2021 11:33:47 AM

WS view: WS headwall and flapgate at toe.

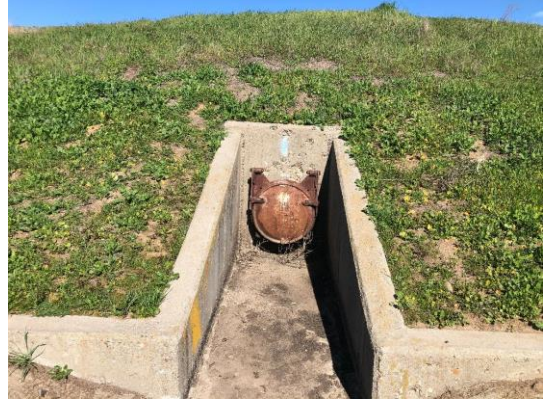
Photo 2 of 3 : UCIP_FA_2023_78874_93718.jpg

WS view: WS headwall and flapgate at toe.

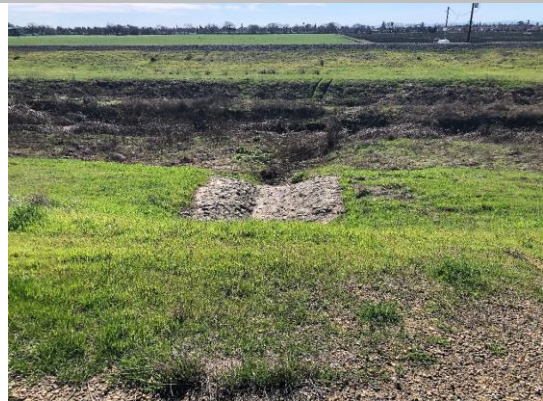
Photo 3 of 3 : UCIP_FA_2023_78874_93719.jpg

WS view: WS headwall at toe from crown.

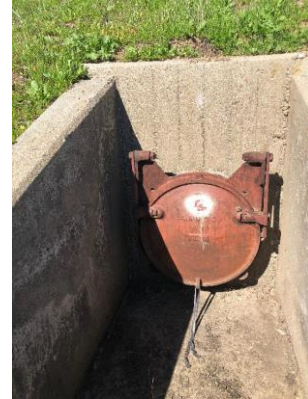
Photo 1 of 3 : UCIP_FA_2023_78875_95535.jpg

Comment Code						
Inspector Comment						
DS_ID:23535 FS_ID:78875 EP_NO: N/A Repair Type: Non-Urgent EVAL Issue: Crossing Status: Found UCIP Comments: 12/20/2022 Record updated from Urgent to Non-Urgent. Pipe has been CIPP lined. LOF of crossing is less or equal to 4. Recommend next video inspection in 5 years. (O.Yakimov - DWR UCIP) 02/17/2021 The record has been upgraded from No Action Needed to Urgent. DWR DMP has found integrity issues, LOF between 5 and 6. Crossing will be monitored until funding becomes available to be addressed. Recommend LMA to prepare contingency plan for increased inspections during high-water. No permit was found authorizing this encroachment. CVFPB will need to review crossing to determine owner. The UCIP inspection was completed with GEI staff, B. Singh, N. Cholewinski, and LMA representative, J. Caruso. (H. Dunn – GEI) FIELD_STRUCT_DESC: 24-inch CIPP-lined corrugated metal storm drainage pipe (CMP) through the levee, 8.0 feet below the crown. Concrete U-shaped headwalls on both ends. Flap gate on the waterside (WS) end. Grouted intake on the landside (LS). Cobble grouted outlet across the berm. [Additional Reference(s): DWR Levee Log, 1987, (HLM 4.37). USACE San Joaquin O&M Manual 612.1, June 1965, (HLM 4.37), and 612 (addendum), February 1999, (HLM 4.33), (Station 228+58), 24-inch pipe listed]. FS Date: 2/17/2021 11:34:22 AM

WS view: Headwall and close up of flapgate.

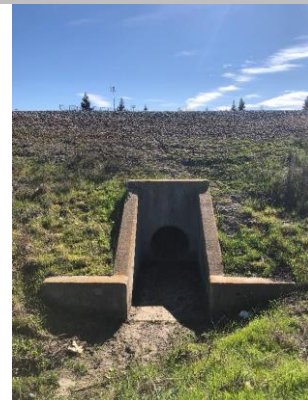
Photo 2 of 3 : UCIP_FA_2023_78875_95536.jpg

LS view: Headwall at toe.

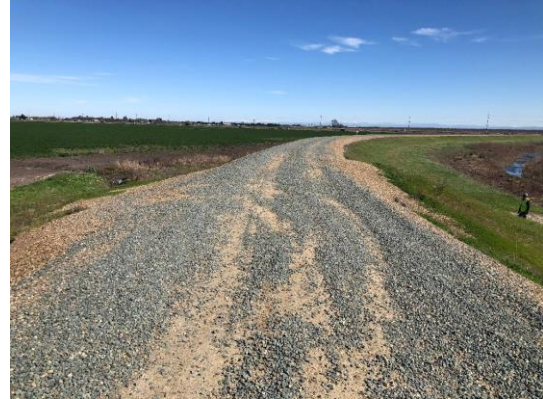
Photo 3 of 3 : UCIP_FA_2023_78875_93735.jpg

Levee crown looking upstream.

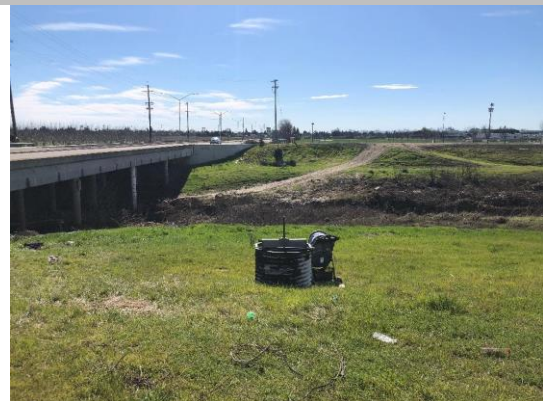
Photo 1 of 3 : UCIP_FA_2023_78288_93742.jpg

DS_ID:23536
 FS_ID:78288
 EP_NO: N/A
 Repair Type: Non-Urgent
 EVAL Issue: 4b, Safety Issue
 Crossing Status: Found
 UCIP Comments: 02/17/2021 The record has been upgraded from No Action Needed to Non-Urgent. LS concrete liner around riser is cracked and misaligned, as well as no cover. DWR DMP Geophysical study indicates possible presence of pipe through levee at 38.0444641, -121.2956106, coordinates have been updated. Owner needs to coordinate with the CVFPB to remove or abandon crossing according to Title 23 requirements. No permit was found authorizing this encroachment. CVFPB will need to review crossing to determine owner. The UCIP inspection was completed with GEI staff, B. Singh, N. Cholewinski, and LMA representative, J. Caruso. (H. Dunn – GEI)
 FIELD_STRUCT_DESC: 24-inch corrugated metal pipe (CMP) siphon through the levee, 10.4 feet below the crown. Slide gate in a 36-inch CMP riser unit on the waterside (WS) slope. Siphon cleanout in center of channel. Slide gate in concrete standpipe at the landside (LS) toe.

WS view: WS toe from crown, metal riser with slidegate.

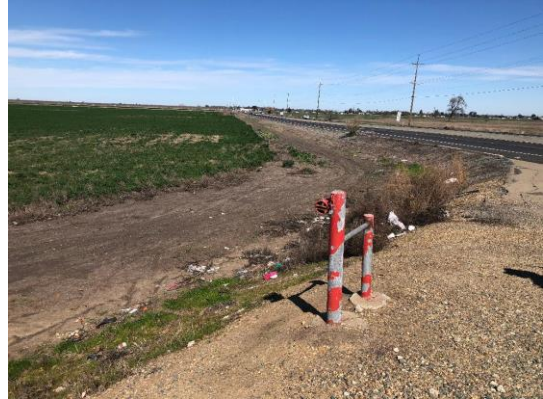
Photo 2 of 3 : UCIP_FA_2023_78288_93743.jpg

LS view: LS toe from crown, metal riser with slidegate.

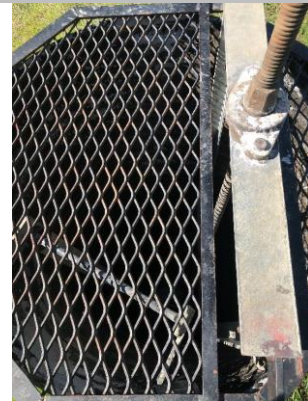
Photo 3 of 3 : UCIP_FA_2023_78288_95547.jpg

WS view: Inside metal riser with slidegate.

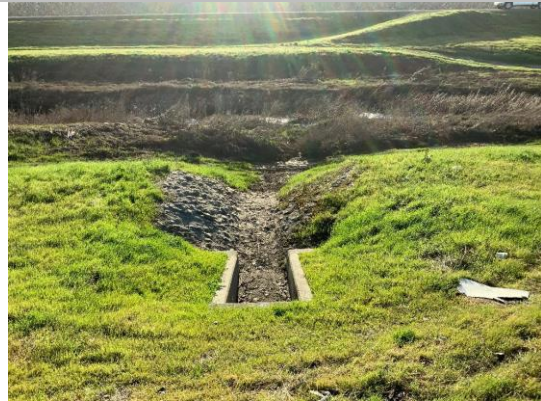
Photo 1 of 3 : UCIP_FA_2023_78942_91205.jpg

Comment Code						
Inspector Comment						
DS_ID:23538 FS_ID:78942 EP_NO: N/A Repair Type: Non-Urgent EVAL Issue: Crossing Status: Found UCIP Comments: 02/18/2021 The record has been upgraded from No Action Needed to Non-Urgent. DWR DMP has not found internal issues, LOF between 1 and 2. Recommend inspection in 5 years. True location was around 20 feet south, coordinates have been updated to 38.0450489, -121.2950334. No permit was found authorizing this encroachment. CVFPB will need to review crossing to determine owner. The UCIP inspection was completed with GEI staff, B. Singh and LMA representative, M. Mccoy. (H. Dunn – GEI) FIELD_STRUCT_DESC: 24-inch corrugated metal drainage pipe (CMP) through the levee, 8.3 feet below the crown. Concrete U-shaped headwalls on both ends. Flap gate on the waterside (WS) end. Grouted intake on the landside (LS). Cobble grouted outlet across the berm. [Additional Reference(s): DWR Levee Log, 1987, (HLM 4.65). USACE San Joaquin O&M Manual 612.1, June 1965, (HLM 4.66), 24-inch pipe listed]. FS Date: 2/18/2021

WS view: WS headwall at toe from crown.

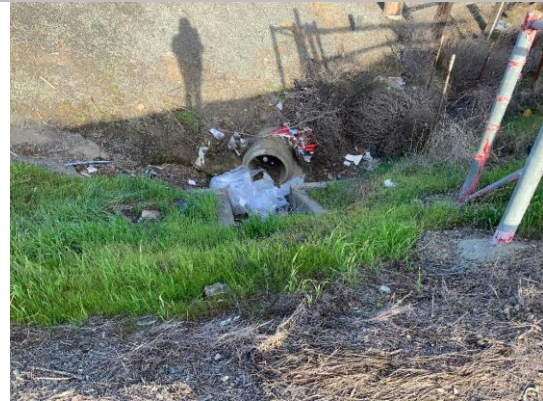
Photo 3 of 3 : UCIP_FA_2023_78942_91207.jpg

LS view: LS headwall at toe from crown.

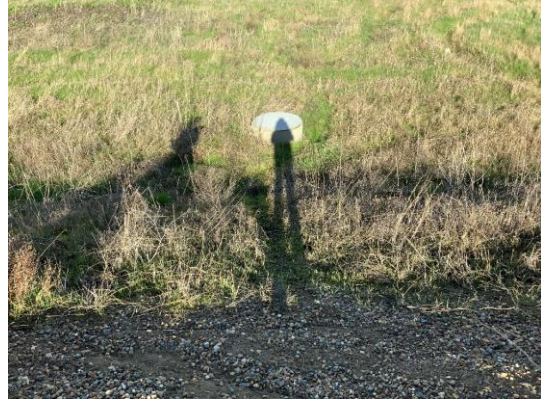
Photo 1 of 3 : UCIP_FA_2023_78877_91229.jpg

Comment Code						
Inspector Comment						
DS_ID:23540 FS_ID:78877 EP_NO: N/A Repair Type: Non-Urgent EVAL Issue: Crossing Status: Found UCIP Comments: 12/20/2022 Record updated from Urgent to Non-Urgent. Pipe has been CIPP lined. LOF of crossing is less or equal to 4. Recommend next video inspection in 5 years. (O.Yakimov - DWR UCIP) 02/18/2021 The record has been upgraded from No Action Needed to Urgent. DWR DMP has found integrity issues, LOF between 5 and 6. Crossing will be monitored until funding becomes available to be addressed. No permit was found authorizing this encroachment. CVFPB will need to review crossing to determine owner. The UCIP inspection was completed with GEI staff, B. Singh and LMA representative, M. Mccoy. (H. Dunn ? GEI) FIELD_STRUCT_DESC: 24-inch CIPP-lined corrugated metal storm drainage pipe (CMP) through the levee, 8.8 feet below the crown. 44-inch concrete standpipe on the landside (LS) toe. Concrete U-shaped headwall on the waterside (WS) end. Flap gate on the WS end. Cobble grouted outlet across the berm. [Additional Reference(s): DWR Levee Log, 1987, (HLM 4.88). USACE San Joaquin O&M Manual 612.1, June 1965, (HLM 4.88), and 612 (addendum), February 1999, (HLM 4.88), (Station 257+60), 24-inch pipe listed]. FS Date: 2/18/2021 11:34:57 AM

LS view: Concrete standpipe on LS toe from crown.

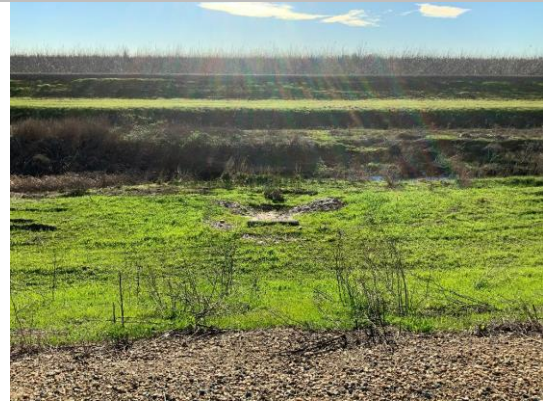
Photo 3 of 3 : UCIP_FA_2023_78877_91231.jpg

WS view: Headwall at WS toe from crown.

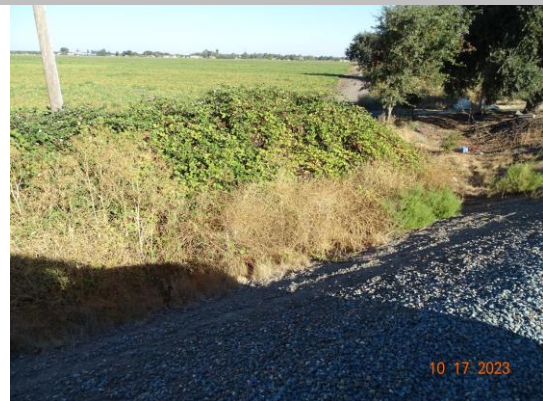
Photo 1 of 1 : FA_2023_NA0017_151_241_20231101_00358.jpg

LM Start	4.94	Rating **	U	Issue No.	241
LM End	4.94	Issue Type +	Ma	Location *	LS
Category	Earthen Levee			GPS Latitude/Longitude	
				Start	End
Item	Vegetation			38.050361°	38.050361°
				-121.286959°	-121.286959°
DWR ID	DWR_NA0017_07_s_2022_241				
Comment Code					
V2 : Remove the wild growth and woody vegetation other than native grasses from the levee slopes.					
Inspector Comment

View of wild growth vegetation along the landside slope and easement.
Fall 2023

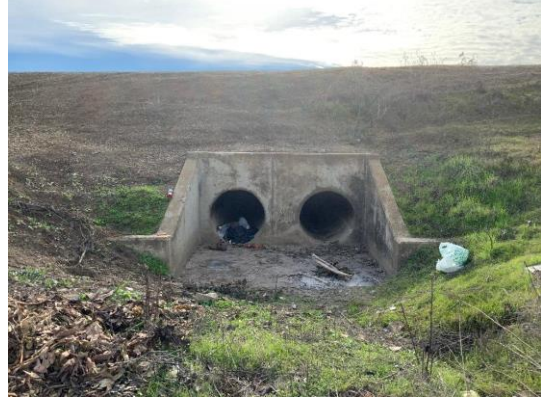
Photo 3 of 3 : UCIP_FA_2023_78878_91295.jpg

LS view: Headwall and pipes on LS toe.

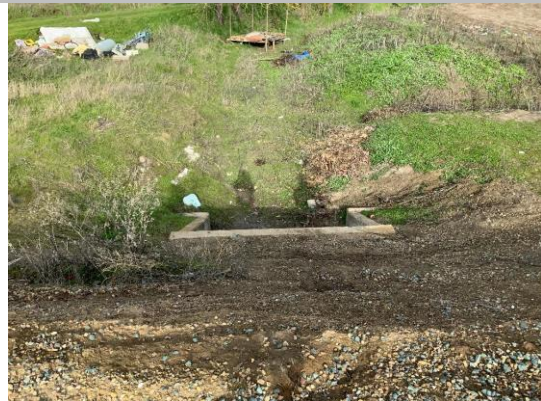
Photo 1 of 3 : UCIP_FA_2023_78879_91399.jpg

DS_ID:23678
 FS_ID:78879
 EP_NO: N/A
 Repair Type: Non-Urgent
 EVAL Issue:
 Crossing Status: Found
 UCIP Comments: 02/18/2021 Pipe status is still Non-Urgent. DWR DMP has not found internal issues, LOF between 1 and 2. Recommend inspection in 5 years. Minor debris inside LS pipe. No permit was found authorizing this encroachment. CVFPB will need to review crossing to determine owner. The UCIP inspection was completed with GEI staff, B. Singh and LMA representative, M. McCoy. (H. Dunn – GEI)
 FIELD_STRUCT_DESC: 2 of 2: 36-inch corrugated metal storm drainage pipe (CMP) through the levee, 8.9 feet below the crown. Concrete U-shaped headwall on both ends. Flap gate on the waterside (WS) end. Grouted intake on the landside (LS). Cobble grouted outlet across the berm. [Additional Reference(s): DWR Levee Log, 1987, (HLM 5.33). USACE San Joaquin O&M Manual 612.1, June 1965, (HLM 5.33), 36-inch pipe listed].

LS view: LS headwall at toe from crown.

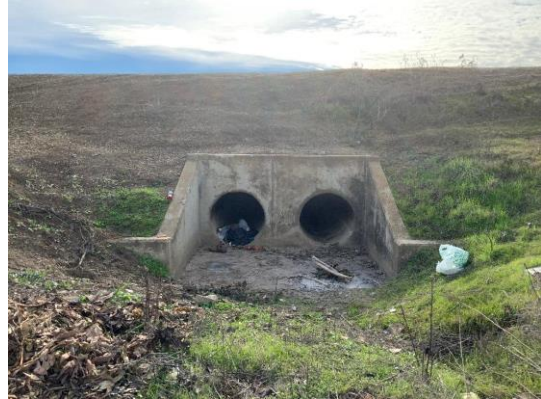
Photo 2 of 3 : UCIP_FA_2023_78879_91400.jpg

LS view: LS headwall and pipes at toe.

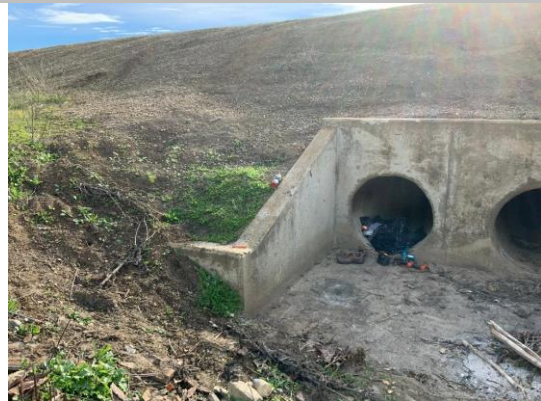
Photo 3 of 3 : UCIP_FA_2023_78879_91402.jpg

LS view: LS headwall and pipe at toe.

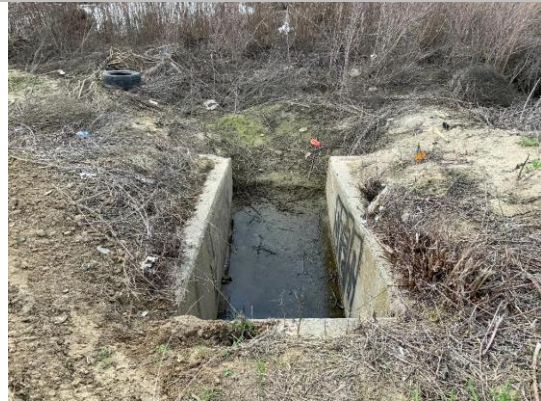
Photo 1 of 3 : UCIP_FA_2023_78880_91418.jpg

DS_ID:23544
FS_ID:78880
EP_NO: N/A
Repair Type: Non-Urgent
EVAL Issue: 6, Levee Damage or Threat for Levee Damage
Crossing Status: Found
UCIP Comments: 12/20/2022 Record updated from Urgent to Non-Urgent. Pipe has been CIPP lined. DMP internal video inspection has found none or minor pipe defects. Recommend next video inspection in 5 years. (O.Yakimov - DWR UCIP)
02/18/2021 The record has been upgraded from No Action Needed to Urgent. Outside edges of WS pipe are warped with minor erosion on WS slope along pipe alignment. DWR DMP has found integrity issues, LOF between 5 and 6. Crossing will be monitored until funding becomes available to address. No permit was found authorizing this encroachment. CVFPB will need to review crossing to determine owner. The UCIP inspection was completed with GEI staff, B. Singh and LMA representative, M. McCoy. (H. Dunn – GEI)
FIELD_STRUCT_DESC: 36-inch CIPP-lined corrugated metal storm drainage pipe (CMP) through the levee, 10.6 feet below the crown. Concrete U-shaped headwall on the waterside (WS) end. Flap gate on the WS end. Cobble grouted outlet across the berm. [Additional Reference(s): DWR Levee Log, 1987, (HLM 5.87). USACE San Joaquin O&M Manual 612.1, June 1965, (HLM 5.87), and 612 (addendum), February 1999, (HLM 5.81), (Station 306+88), 36-inch pipe listed].

WS view: WS headwall at toe from crown.

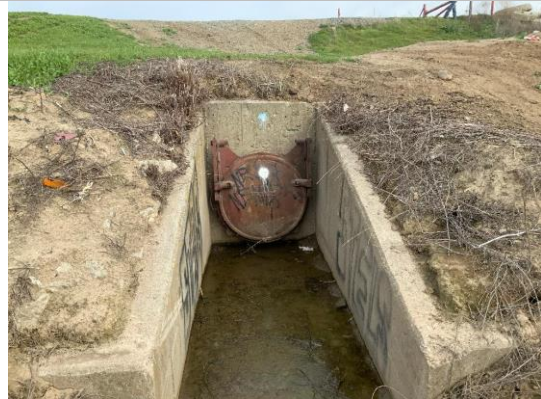
Photo 2 of 3 : UCIP_FA_2023_78880_91419.jpg

WS view: WS headwall and flagate at toe.

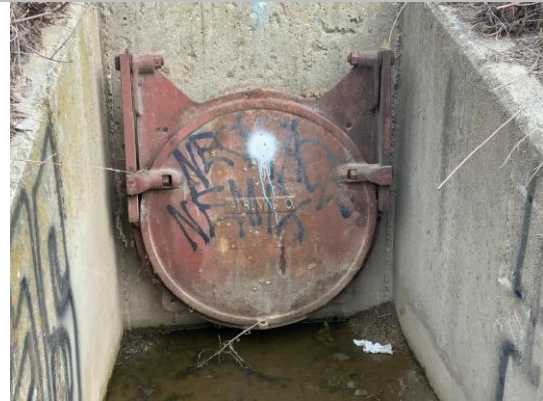
Photo 3 of 3 : UCIP_FA_2023_78880_91415.jpg

WS view: WS flapgate.

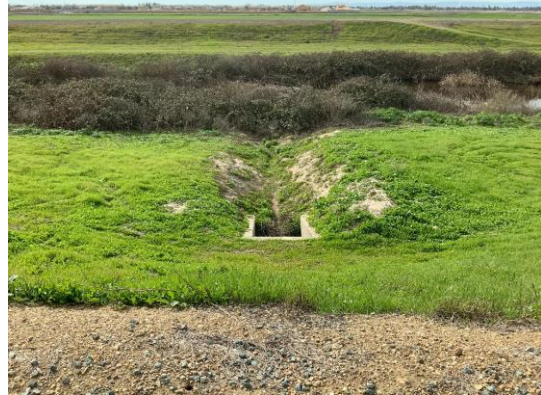
Photo 1 of 3 : UCIP_FA_2023_78882_91739.jpg

Comment Code						
Inspector Comment						
DS_ID:23546						
FS_ID:78882						
EP_NO: N/A						
Repair Type: Urgent						
EVAL Issue: 1, Pipe Integrity						
Crossing Status: Found						
UCIP Comments: 02/18/2021 The record has been upgraded from Non-Urgent to Urgent. No LS pipe visible, and LMA has confirmed that the pipe is abandoned, has been grouted, and will be removed within 5 years. DWR DMP has found integrity issues, LOF between 5 and 6. Crossing will be monitored until funding becomes available for it to be addressed. No permit was found authorizing this encroachment. CVFPB will need to review crossing to determine owner. The UCIP inspection was completed with GEI staff, B. Singh and LMA representative, M. McCoy. (H. Dunn – GEI) 05/15/2014 Inlet buried at LS toe. Pipe may be abandoned and if so should be done so properly. (W. Wylie - DWR UCIP)						
FIELD_STRUCT_DESC: 36-inch corrugated metal drainage pipe (CMP) through the levee, 7.9 feet below the crown. Concrete U-shaped headwall on the waterside (WS) end. Concrete headwall on the landside (LS). Flap gate on the WS end. Cobble grouted outlet across the berm. [Additional Reference(s): DWR Levee Log, 1987, (HLM 5.97). USACE San Joaquin O&M Manual 612.1, June 1965, (HLM 5.97), 36-inch pipe listed].

WS view: WS headwall at toe from crown.

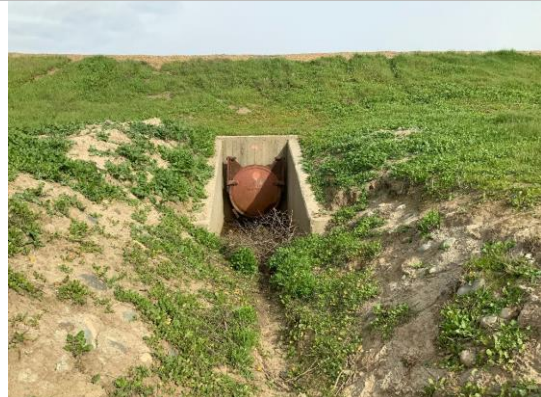
Photo 2 of 3 : UCIP_FA_2023_78882_91740.jpg

WS view: WS headwall and flapgate at toe.

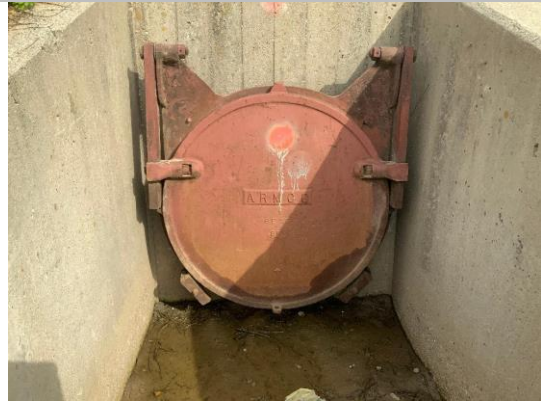
Photo 3 of 3 : UCIP_FA_2023_78882_91737.jpg

WS view: WS flapgate at toe.

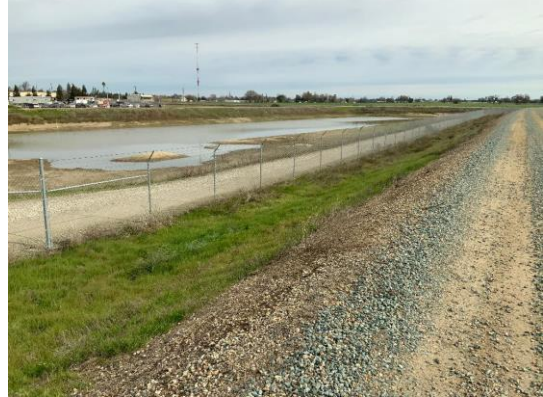
Photo 2 of 3 : UCIP_FA_2023_78306_91768.jpg

DS_ID:23549
 FS_ID:78306
 EP_NO: N/A
 Repair Type: Non-Urgent
 EVAL Issue:
 Crossing Status: Not Found
 UCIP Comments: 02/18/2021 The record has been upgraded from No Action Needed to Non-Urgent. Pipe not found by visual inspection. DWR DMP geophysical study did not confirm presence of pipe through levee. Record will remain in UCIP's inspection records until future Levee Improvement Project can confirm no crossing was found through the levee. LMA has confirmed that a stretch of multiple pipes have been removed in this levee mile, including this one. The UCIP inspection was completed with GEI staff, B. Singh and LMA representative, M. McCoy. (H. Dunn – GEI)
 FIELD_STRUCT_DESC: 24-inch corrugated metal drainage pipe (CMP) through the levee, 6.9 feet below the crown. Concrete U-shaped headwall on both ends. Flap gate on the waterside (WS) end. Grouted intake on the landside (LS). [Additional Reference(s): DWR Levee Log, 1987, (HLM 6.05). USACE San Joaquin O&M Manual 612.1, June 1965, (HLM 6.06), 24-inch pipe listed].

LS view: LS toe from crown, pipe removed.

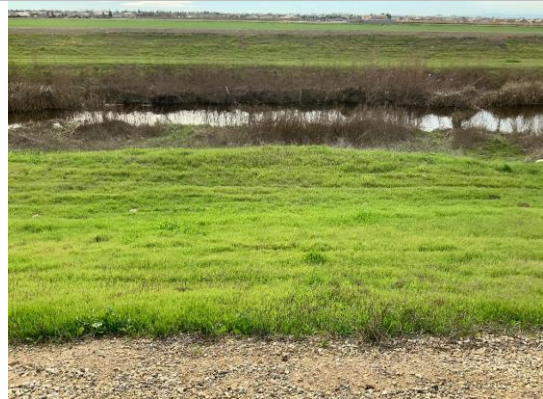
Photo 3 of 3 : UCIP_FA_2023_78306_91769.jpg

WS view: WS toe from crown, pipe removed.

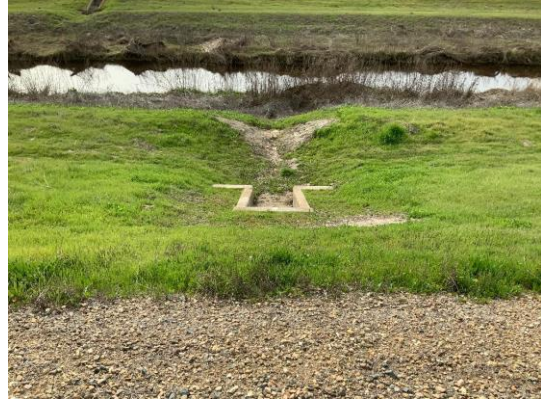
Photo 1 of 3 : UCIP_FA_2023_78943_91770.jpg

Comment Code						
Inspector Comment						
DS_ID:23550 FS_ID:78943 EP_NO: N/A Repair Type: Non-Urgent EVAL Issue: Crossing Status: Found UCIP Comments: 12/20/2022 Record updated from Urgent to Non-Urgent. Pipe has been CIPP lined. LOF of crossing is less or equal to 4. Recommend next video inspection in 5 years. (O.Yakimov - DWR UCIP) 02/18/2021 The record has been upgraded from No Action Needed to Urgent. DWR DMP has found integrity issues, LOF between 5 and 6. Crossing will be monitored until funding becomes available for it to be addressed. No permit was found authorizing this encroachment. CVFPB will need to review crossing to determine owner. The UCIP inspection was completed with GEI staff, B. Singh and LMA representative, M. Mccoy. (H. Dunn – GEI) FIELD_STRUCT_DESC: 24-inch CIPP-lined corrugated metal drainage pipe (CMP) through the levee, 5.9 feet below the crown. Concrete U-shaped headwalls on both ends. Flap gate on the waterside (WS) end. Grouted intake on the landside (LS). Cobble grouted outlet across the berm. [Additional Reference(s): DWR Levee Log, 1987, (HLM 6.20). USACE San Joaquin O&M Manual 612.1, June 1965, (HLM 6.20), 24-inch pipe listed]. FS Date: 2/18/2021 11:36:16 AM

WS view: WS headwall at toe from crown.

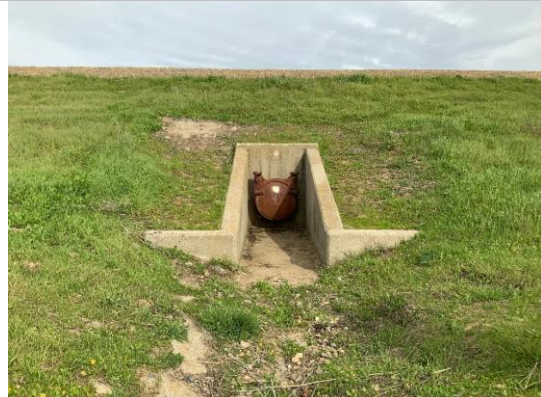
Photo 2 of 3 : UCIP_FA_2023_78943_91771.jpg

WS view: WS headwall and flapgate at toe.

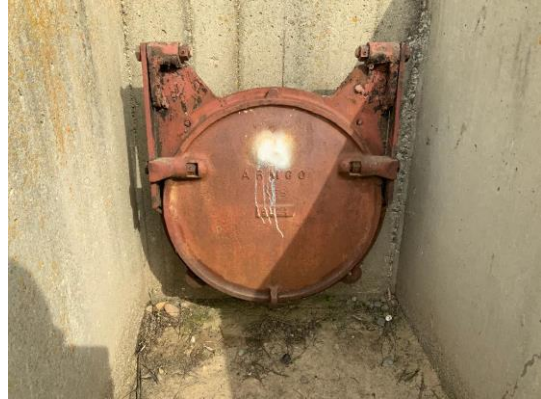
Photo 3 of 3 : UCIP_FA_2023_78943_91772.jpg

WS view: WS flapgate at toe.

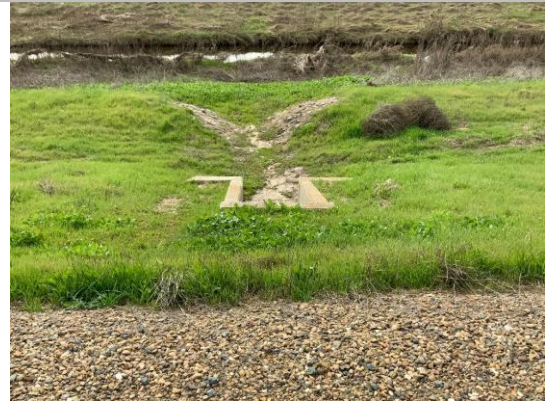
Photo 1 of 3 : UCIP_FA_2023_78884_91777.jpg

Comment Code						
Inspector Comment						
DS_ID:23551 FS_ID:78884 EP_NO: N/A Repair Type: No Action Needed EVAL Issue: Crossing Status: Found UCIP Comments: 09/18/2023 Record updated from Non-Urgent to No Action Needed. Pipe was CIPP lined. DMP internal video inspection has found none or minor pipe defects. Recommend next video inspection in 5 years. (O. Yakimov - DWR UCIP) 02/18/2021 Pipe status is still Non-Urgent. DWR DMP has found integrity issues, LOF between 4 and 5. Crossing will be monitored until funding becomes available for rehabilitation. No permit was found authorizing this encroachment. CVFPB will need to review crossing to determine owner. The UCIP inspection was completed with GEI staff, B. Singh and LMA representative, M. Mccoy. (H. Dunn – GEI) 05/15/2014 Sediment buildup in pipe at LS toe. (W. Wylie - DWR UCIP) FIELD_STRUCT_DESC: 24-inch CIPP-lined corrugated metal storm drainage pipe (CMP) through the levee, 5.5 feet below the crown. Concrete U-shaped headwalls on both ends. Flap gate on the waterside (WS) end. Grouted intake on the landside (LS). Cobble grouted outlet across the berm. [Additional Reference(s): DWR Levee Log, 1987, (HLM 6.32). USACE San Joaquin O&M Manual 612.1, June 1965, (HLM 6.32), and 612 (addendum), February 1999, (HLM 6.34), (Station 334+54), 36-inch pipe listed]. FS Date: 2/18/2021

WS view: WS headwall at toe from crown.

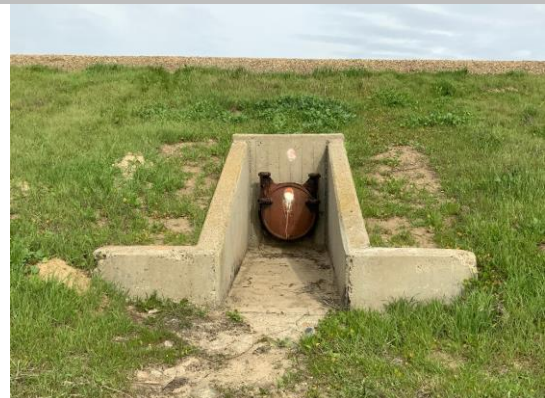
Photo 2 of 3 : UCIP_FA_2023_78884_91778.jpg

WS view: WS headwall and flapgate at toe.

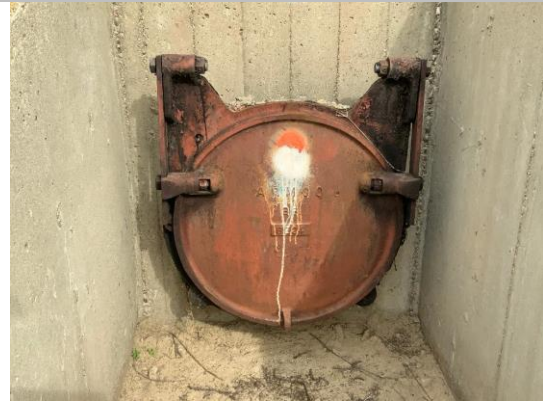
Photo 3 of 3 : UCIP_FA_2023_78884_91779.jpg

WS view: WS flapgate at toe.

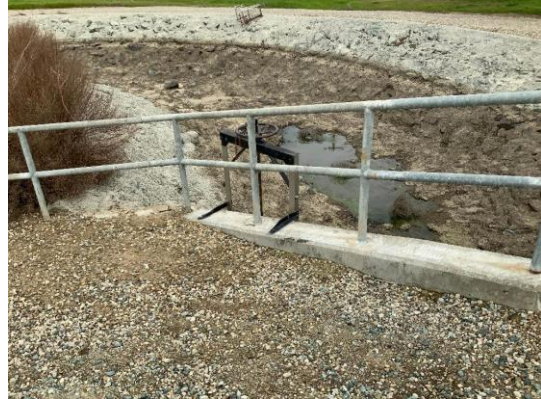
Photo 1 of 3 : UCIP_FA_2023_78944_91804.jpg

Comment Code						
Inspector Comment						
DS_ID:23552						
FS_ID:78944						
EP_NO: N/A						
Repair Type: Non-Urgent						
EVAL Issue: 6, Levee Damage or Threat for Levee Damage						
Crossing Status: Found						
UCIP Comments: 02/18/2021 The record has been upgraded from No						
Action Needed to Non-Urgent. DWR DMP has not found internal issues,						
LOF between 1 and 2. Recommend inspection in 5 years. Cracking in						
soil on WS berm (4 feet), recommend monitoring area for material loss.						
No permit was found authorizing this encroachment. CVFPB will need						
to review crossing to determine owner. The UCIP inspection was						
completed with GEI staff, B. Singh and LMA representative, M. McCoy.

LS view: LS headwall at toe from crown.

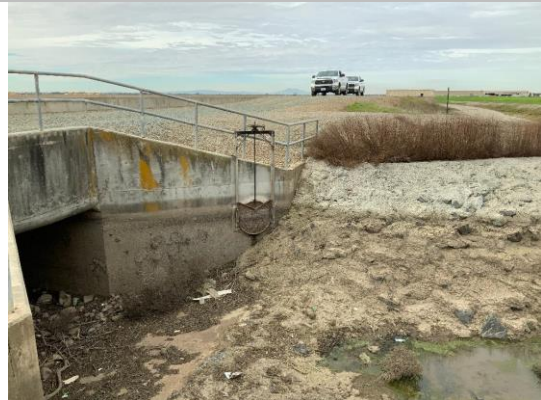
Photo 2 of 3 : UCIP_FA_2023_78944_91805.jpg

LS view: LS headwall and slide gate at toe.

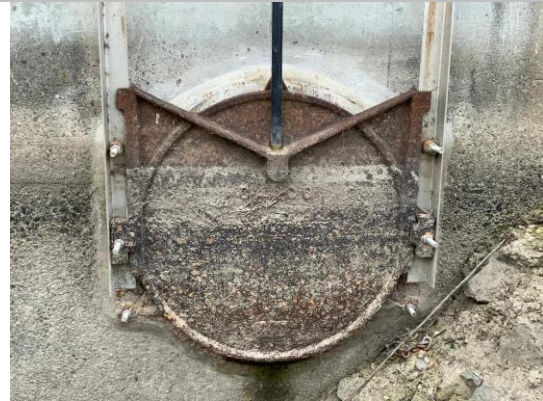
Photo 3 of 3 : UCIP_FA_2023_78944_91806.jpg

LS view: LS slide gate at toe.

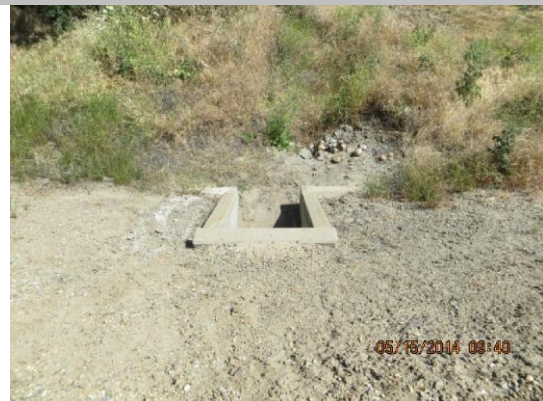
Photo 1 of 3 : UCIP_FA_2023_78945_68873.jpg

DS_ID:23554
 FS_ID:78945
 EP_NO: N/A
 Repair Type: No Action Needed
 EVAL Issue:
 Crossing Status: Found
 UCIP Comments: 09/18/2023 Record updated from Non-Urgent to No Action Needed. Pipe was CIPP lined. DMP internal video inspection has found none or minor pipe defects. Recommend next video inspection in 5 years. (O. Yakimov - DWR UCIP)
 02/18/2021 The record has been upgraded from No Action Needed to Non-Urgent. DWR DMP has found integrity issues, LOF between 4 and 5. Crossing will be monitored until funding becomes available for rehabilitation. No permit was found authorizing this encroachment. CVFPB will need to review crossing to determine owner. The UCIP inspection was completed with GEI staff, B. Singh and LMA representative, M. McCoy. (H. Dunn – GEI)
 FIELD_STRUCT_DESC: 24-inch CIPP-lined corrugated metal storm drainage pipe (CMP) through the levee, 5.3 feet below the crown. Concrete U-shaped headwalls on both ends. Flap gate on the waterside (WS) end. Grouted intake on the landside (LS). Cobble grouted outlet across the berm. [Additional Reference(s): DWR Levee Log, 1987, (HLM 6.53). USACE San Joaquin O&M Manual 612.1, June 1965, (HLM 6.53), 24-inch pipe listed].

Headwall on LS toe.

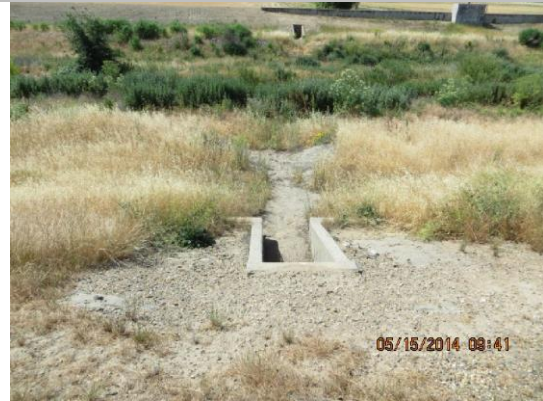
Photo 2 of 3 : UCIP_FA_2023_78945_68872.jpg

Headwall, flap gate, and cobble grouted outlet on WS toe.

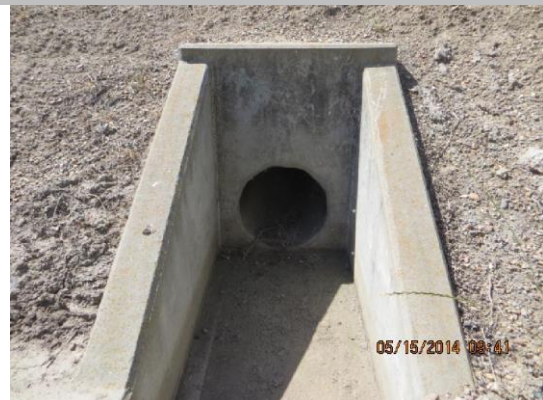
Photo 3 of 3 : UCIP_FA_2023_78945_68871.jpg

Headwall on LS toe.

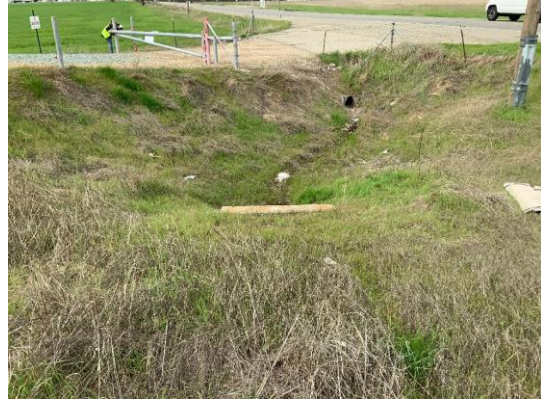
Photo 1 of 3 : UCIP_FA_2023_78947_91834.jpg

Comment Code						
Inspector Comment						
DS_ID:23555 FS_ID:78947 EP_NO: N/A Repair Type: No Action Needed EVAL Issue: Crossing Status: Found UCIP Comments: 09/18/2023 Record updated from Non-Urgent to No Action Needed. Pipe was CIPP lined. DMP internal video inspection has found none or minor pipe defects. Recommend next video inspection in 5 years. (O. Yakimov - DWR UCIP) 02/18/2021 The record has been upgraded from No Action Needed to Non-Urgent. DWR DMP has found integrity issues, LOF between 4 and 5. Crossing will be monitored until funding becomes available for rehabilitation. No permit was found authorizing this encroachment. CVFPB will need to review crossing to determine owner. The UCIP inspection was completed with GEI staff, B. Singh and LMA representative, M. Mccoy. (H. Dunn – GEI) FIELD_STRUCT_DESC: 24-inch CIPP-lined corrugated metal storm drainage pipe (CMP) through the levee, 6.7 feet below the crown. Concrete U-shaped headwalls on both ends. Flap gate on the waterside (WS) end. Grouted intake on the landside (LS). Cobble grouted outlet across the berm. [Additional Reference(s): DWR Levee Log, 1987, (HLM 6.85). USACE San Joaquin O&M Manual 612.1, June 1965, (HLM 6.85), 24-inch pipe listed]. FS Date: 2/18/2021

LS view: LS headwall at toe from crown.

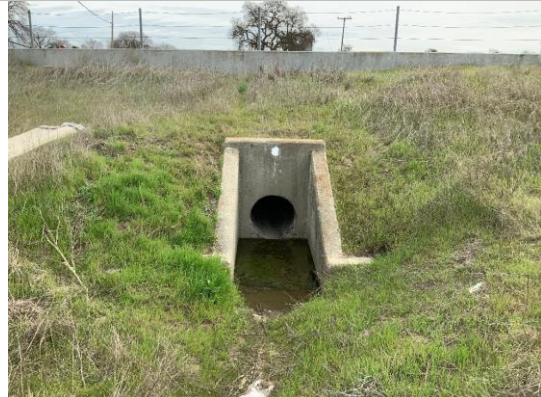
Photo 2 of 3 : UCIP_FA_2023_78947_91835.jpg

LS view: LS headwall at toe.

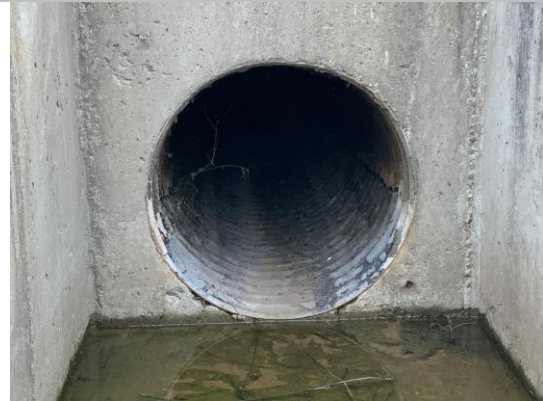
Photo 3 of 3 : UCIP_FA_2023_78947_91836.jpg

LS view: LS pipe.

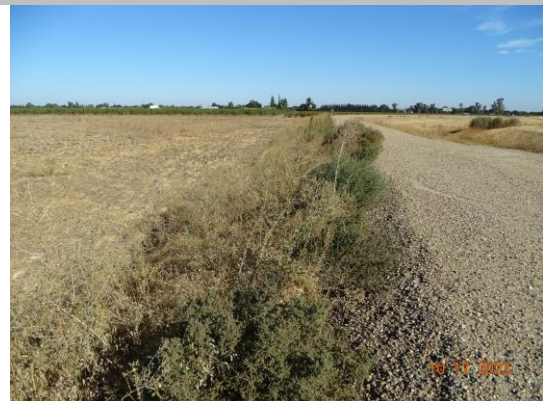
Photo 1 of 1 : FA_2023_NA0017_151_150_20231101_00359.jpg

LM Start	6.47	Rating **	U	Issue No.	150
LM End	6.63	Issue Type +	Ma	Location *	LS
Category	Earthen Levee			GPS Latitude/Longitude	
				Start	End
Item	Vegetation			38.057545°	38.059642°
				-121.262406°	-121.261342°
DWR ID	DWR_NA0017_07_f_2023_150				
Comment Code					
V2 : Remove the wild growth and woody vegetation other than native grasses from the levee slopes.					
Inspector Comment

Typical view of wild growth vegetation along the landside slope and easement. Fall 2023

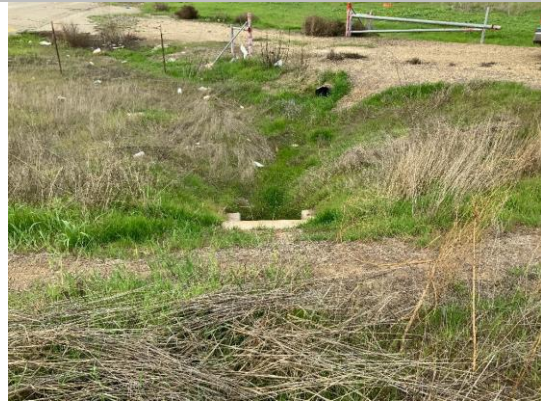
Photo 1 of 3 : UCIP_FA_2023_78948_91844.jpg

Comment Code					
Inspector Comment					
DS_ID:23556 FS_ID:78948 EP_NO: N/A Repair Type: No Action Needed EVAL Issue: Crossing Status: Found UCIP Comments: 09/18/2023 Record updated from Non-Urgent to No Action Needed. Pipe was CIPP lined. DMP internal video inspection has found none or minor pipe defects. Recommend next video inspection in 5 years. (O. Yakimov - DWR UCIP) 02/18/2021 Pipe status is still Non-Urgent. DWR DMP has found integrity issues, LOF between 4 and 5. Crossing will be monitored until funding becomes available for rehabilitation. The UCIP inspection was completed with GEI staff, B. Singh and LMA representative, M. McCoy. (H. Dunn – GEI) 05/15/2014 Some silt buildup inside pipe at LS toe. (W. Wylie - DWR UCIP) FIELD_STRUCT_DESC: 24-inch CIPP-lined corrugated metal storm drainage pipe (CMP) through the levee, 6.0 feet below the crown. Concrete U-shaped headwalls on both ends. Flap gate on the waterside (WS) end. Grouted intake on the landside (LS) end. Cobble grouted outlet across the berm. [Additional Reference(s): DWR Levee Log, 1987, (HLM 6.88). USACE San Joaquin O&M Manual 612.1, June 1965, (HLM 6.88), and 612 (addendum), February 1999, (HLM 6.95), (Station 367+11), 24-inch pipe listed]. FS Date: 2/18/2021

LS view: LS headwall at toe from crown.

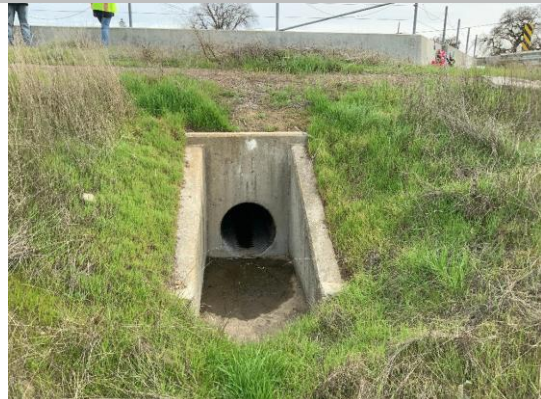
Photo 2 of 3 : UCIP_FA_2023_78948_91845.jpg

LS view: LS headwall at toe.

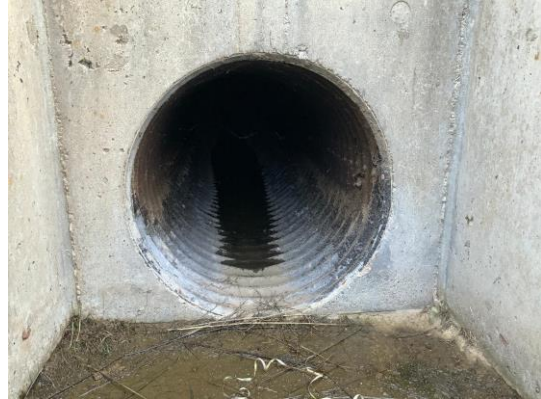
Photo 3 of 3 : UCIP_FA_2023_78948_91846.jpg

LS view: LS pipe.

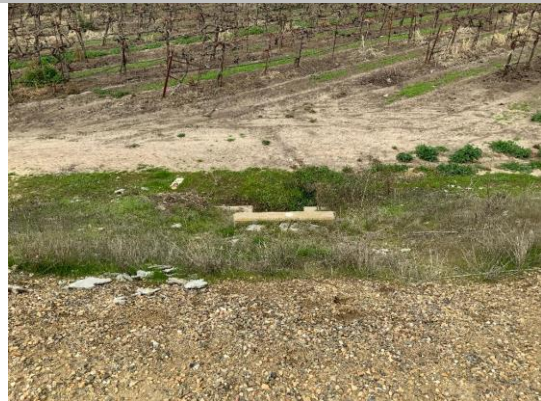
Photo 1 of 3 : UCIP_FA_2023_78889_91851.jpg

LS view: LS headwall at toe from crown.

Comment Code					
Inspector Comment					
DS_ID:23557 FS_ID:78889 EP_NO: N/A Repair Type: No Action Needed EVAL Issue: Crossing Status: Found UCIP Comments: 09/18/2023 Record updated from Non-Urgent to No Action Needed. Pipe was CIPP lined. DMP internal video inspection has found none or minor pipe defects. Recommend next video inspection in 5 years. (O. Yakimov - DWR UCIP) 02/18/2021 The record has been upgraded from No Action Needed to Non-Urgent. DWR DMP has found integrity issues, LOF between 4 and 5. Crossing will be monitored until funding becomes available for rehabilitation. No permit was found authorizing this encroachment. CVFPB will need to review crossing to determine owner. The UCIP inspection was completed with GEI staff, B. Singh and LMA representative, M. McCoy. (H. Dunn – GEI) FIELD_STRUCT_DESC: 24-inch CIPP-lined corrugated metal storm drainage pipe (CMP) through the levee, 6.5 feet below the crown. Concrete U-shaped headwalls on both ends. Flap gate on the waterside (WS) end. Cobble grouted outlet across the berm. Culvert with slide gate in headwall on the WS. [Additional Reference(s): DWR Levee Log, 1987, (HLM 7.04). USACE San Joaquin O&M Manual 612.1, June 1965, (HLM 7.02), and 612 (addendum), February 1999, (HLM 6.97), (Station 368+08), 24-inch pipe listed]. FS Date: 2/18/2021

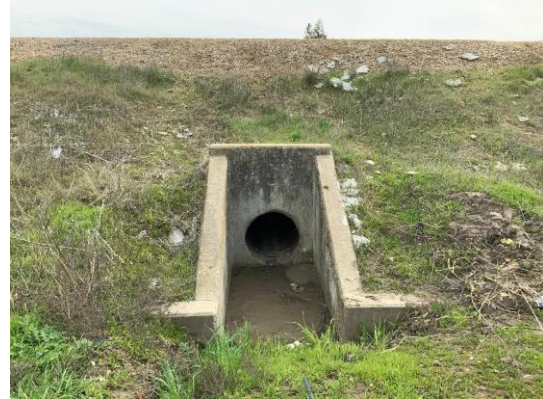
Photo 2 of 3 : UCIP_FA_2023_78889_91852.jpg

LS view: LS headwall at toe.

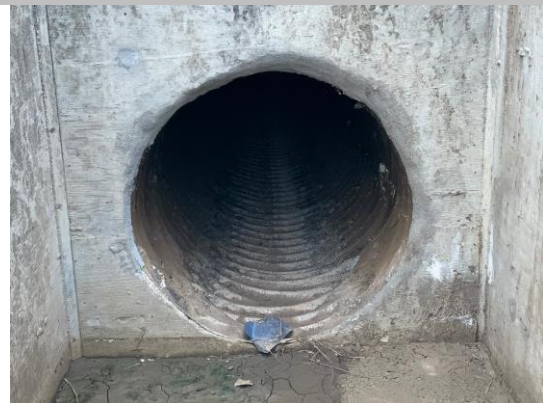
Photo 3 of 3 : UCIP_FA_2023_78889_91853.jpg

LS view: LS pipe.

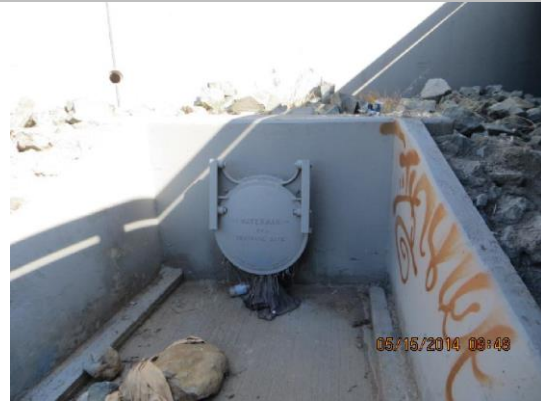
Photo 1 of 3 : UCIP_FA_2023_78890_68857.jpg

Comment Code					
Inspector Comment					
DS_ID:23559 FS_ID:78890 EP_NO: N/A Repair Type: Urgent EVAL Issue: 1, Pipe Integrity Crossing Status: Found UCIP Comments: 02/24/2021 The record has been upgraded from No Action Needed to Urgent. Did not inspect LS due to safety issues (large homeless encampment under freeway). DWR DMP has found integrity issues, LOF between 5 and 6. Crossing will be monitored until funding becomes available to address the issues. No permit was found authorizing this encroachment. CVFPB will need to review crossing to determine owner. The UCIP inspection was completed with GEI staff, B. Singh. (H. Dunn – GEI) FIELD_STRUCT_DESC: 24-inch corrugated metal storm drainage pipe (CMP) through the levee, 9.0 feet below the crown. Concrete U-shaped headwalls on both ends. Flap gate on the waterside (WS) end. Cobble grouted outlet across the berm. Cobble grouted apron on the landside (LS) end. [Additional Reference(s): DWR Levee Log, 1987, (HLM 7.17). USACE As-Built Drawing No. CA3-04-008, Sheet No. 28, 1 February 1963, existing structure just downstream of southbound Highway 99]. FS Date: 2/24/2021

Pipe, headwall, and flapgate on WS toe.

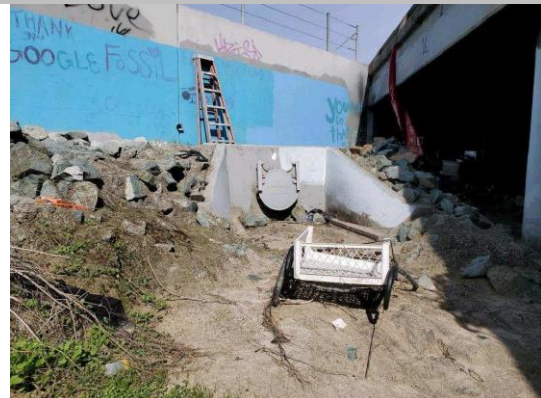
Photo 2 of 3 : UCIP_FA_2023_78890_91860.jpg

WS headwall and flapgate at toe.

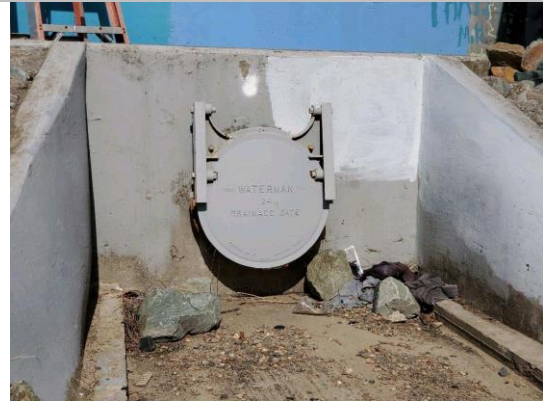
Photo 3 of 3 : UCIP_FA_2023_78890_91861.jpg

WS flapgate at toe.

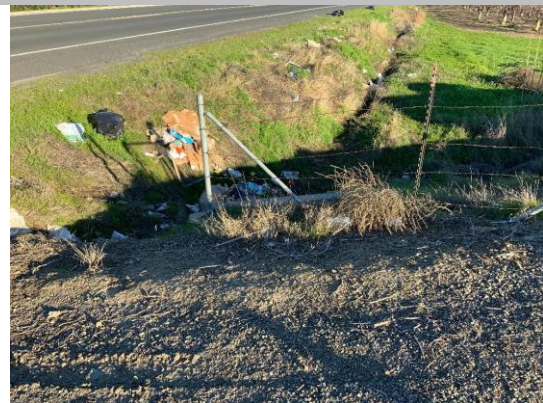
Photo 1 of 3 : UCIP_FA_2023_78892_91867.jpg

DS_ID:23561
FS_ID:78892
EP_NO: N/A
Repair Type: Non-Urgent
EVAL Issue: 6, Levee Damage or Threat for Levee Damage
Crossing Status: Found
UCIP Comments: 02/24/2021 The record has been upgraded from No Action Needed to Non-Urgent. Minor erosion along the right edge of the LS headwall and slope. DWR DMP has not found internal issues, LOF between 1 and 2. Recommend inspection in 5 years. No permit was found authorizing this encroachment. CVFPB will need to review crossing to determine owner. The UCIP inspection was completed with GEI staff, B. Singh. (H. Dunn – GEI)
FIELD_STRUCT_DESC: 36-inch concrete storm drainage pipe through the levee, 8.0 feet below the crown. Concrete U-shaped headwalls on both ends. Flap gate on the waterside (WS) end. Cobble grouted outlet across the berm. Cobble grouted apron on the landside (LS) end.
[Additional Reference(s): DWR Levee Log, 1987, (HLM 7.21). USACE San Joaquin O&M Manual 612.2, 1967, (HLM 7.21), 36-inch pipe listed].

LS headwall at toe from crown.

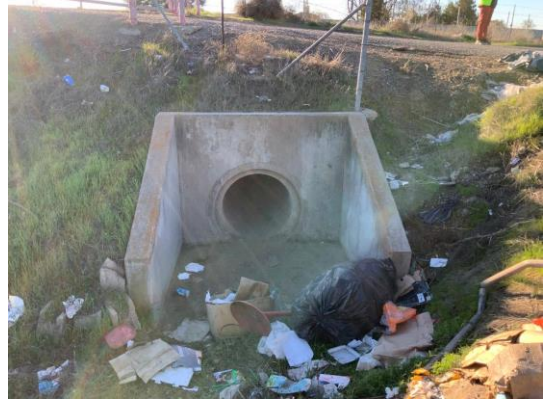
Photo 2 of 3 : UCIP_FA_2023_78892_91868.jpg

LS headwall at toe.

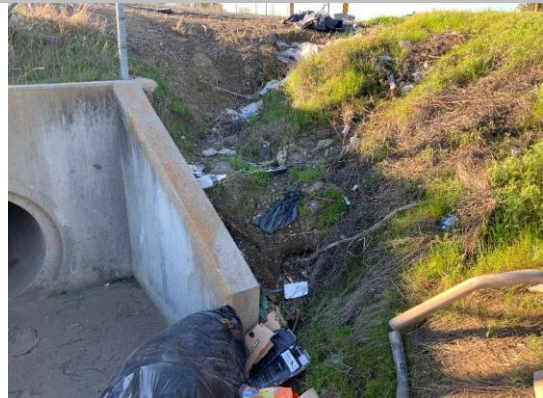
Photo 3 of 3 : UCIP_FA_2023_78892_91862.jpg

LS headwall with minor erosion on slope on side of headwall.

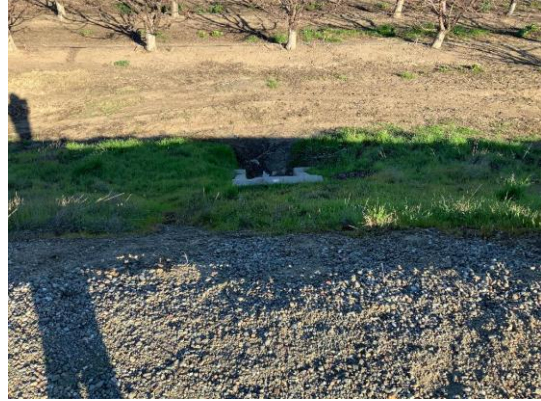
Photo 1 of 3 : UCIP_FA_2023_78949_91882.jpg

Comment Code						
Inspector Comment						
DS_ID:23562 FS_ID:78949 EP_NO: N/A Repair Type: Non-Urgent EVAL Issue: Crossing Status: Found UCIP Comments: 12/20/2022 Record updated from Urgent to Non-Urgent. Pipe has been CIPP lined. LOF of crossing is less or equal to 4. Recommend next video inspection in 5 years. (O.Yakimov - DWR UCIP) 02/24/2021 Record updated from No Action Needed to Urgent. DMP internal video inspection has found pipe integrity issues. LOF of crossing is between 5 and 6. Crossing will be monitored until funding becomes available to address the issues. No permit was found authorizing this encroachment. CVFPB will need to review crossing to determine owner. The UCIP inspection was completed with GEI staff, B. Singh. (H. Dunn – GEI) FIELD_STRUCT_DESC: 24-inch CIPP-lined corrugated metal storm drainage pipe (CMP) through the levee, 8.0 feet below the crown. Concrete U-shaped headwalls on both ends. Flap gate on the waterside (WS) end. Cobble grouted outlet across the berm. Cobble grouted apron on the landside (LS) end. [Additional Reference(s): DWR Levee Log, 1987, (HLM 7.34). USACE San Joaquin O&M Manual 612.2, 1967, (HLM 7.34), and 612 (addendum), February 1999, (HLM 7.30), (Station 385+65), 24-inch pipe listed]. FS Date: 2/24/2021 11:36:56 AM

LS view: LS headwall at toe from crown.

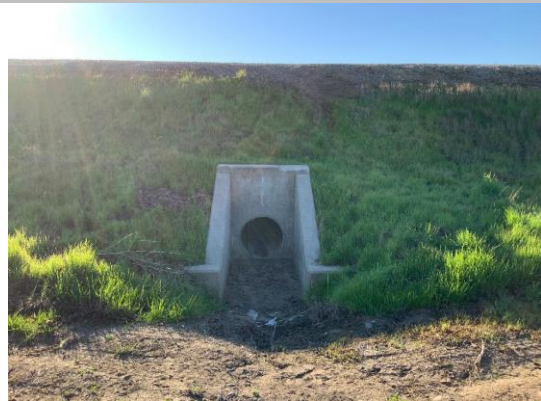
Photo 2 of 3 : UCIP_FA_2023_78949_91883.jpg

LS view: LS headwall at toe.

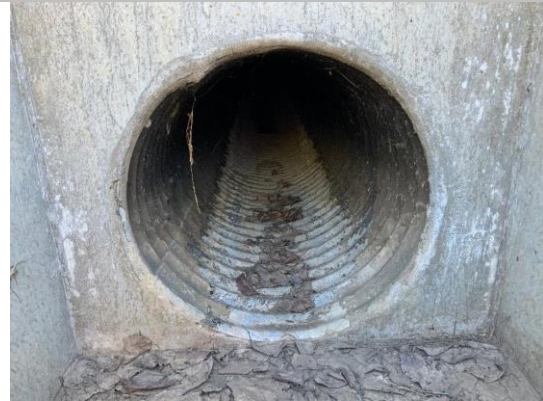
Photo 3 of 3 : UCIP_FA_2023_78949_91884.jpg

LS view: LS pipe.

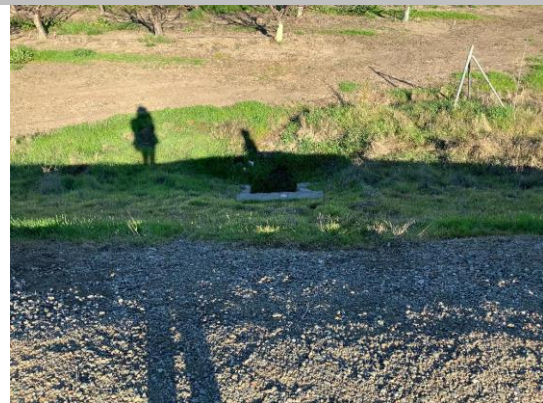
Photo 1 of 3 : UCIP_FA_2023_78950_91889.jpg

DS_ID:23563
 FS_ID:78950
 EP_NO: N/A
 Repair Type: Non-Urgent
 EVAL Issue:
 Crossing Status: Found
 UCIP Comments: 02/24/2021 The record has been upgraded from No Action Needed to Non-Urgent. DWR DMP has not found internal issues, LOF between 1 and 2. Recommend inspection in 5 years. No permit was found authorizing this encroachment. CVFPB will need to review crossing to determine owner. The UCIP inspection was completed with GEI staff, B. Singh. (H. Dunn – GEI)
 FIELD_STRUCT_DESC: 24-inch corrugated metal storm drainage pipe (CMP) through the levee, 7.0 feet below the crown. Concrete U-shaped headwalls on both ends. Flap gate on the waterside (WS) end. Cobble grouted outlet across the berm. Cobble grouted apron on the landside (LS) end. [Additional Reference(s): DWR Levee Log, 1987, (HLM 7.52). USACE San Joaquin O&M Manual 612.2, 1967, (HLM 7.51), and 612 (addendum), February 1999, (HLM 7.45), (Station 393+26), 24-inch pipe listed].

LS headwall at toe from crown.
