**Flood Control Project Maintenance
Levee Inspections**

Maintenance Issue Types Only, Levee Inspection Report By Mile - Fall 2023

San Joaquin County Flood Control and Water Conservation District

Waterway	Bank	Unit Miles	Inspection Start/End	Inspector
Unit No. 01 Littlejohn Creek	Left	2.59	10/20/2023 10/20/2023	Alberto De Leon

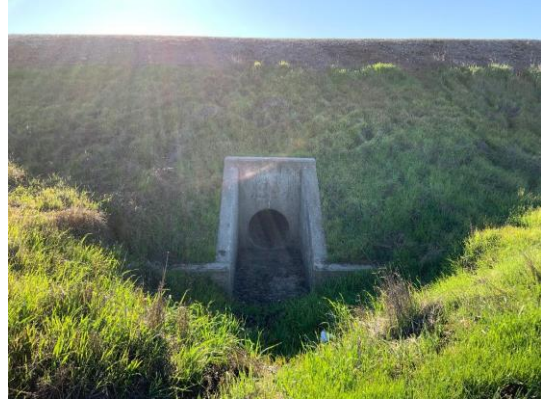
Photo 2 of 3 : UCIP_FA_2023_78950_91890.jpg

DS_ID:23563
 FS_ID:78950
 EP_NO: N/A
 Repair Type: Non-Urgent
 EVAL Issue:
 Crossing Status: Found
 UCIP Comments: 02/24/2021 The record has been upgraded from No Action Needed to Non-Urgent. DWR DMP has not found internal issues, LOF between 1 and 2. Recommend inspection in 5 years. No permit was found authorizing this encroachment. CVFPB will need to review crossing to determine owner. The UCIP inspection was completed with GEI staff, B. Singh. (H. Dunn – GEI)
 FIELD_STRUCT_DESC: 24-inch corrugated metal storm drainage pipe (CMP) through the levee, 7.0 feet below the crown. Concrete U-shaped headwalls on both ends. Flap gate on the waterside (WS) end. Cobble grouted outlet across the berm. Cobble grouted apron on the landside (LS) end. [Additional Reference(s): DWR Levee Log, 1987, (HLM 7.52). USACE San Joaquin O&M Manual 612.2, 1967, (HLM 7.51), and 612 (addendum), February 1999, (HLM 7.45), (Station 393+26), 24-inch pipe listed].

LS headwall at toe.

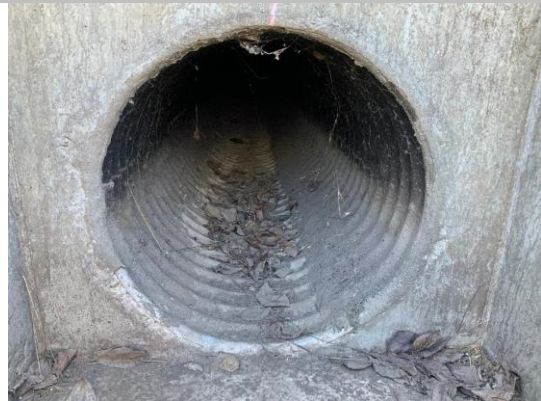
Photo 3 of 3 : UCIP_FA_2023_78950_91891.jpg

LS pipe.

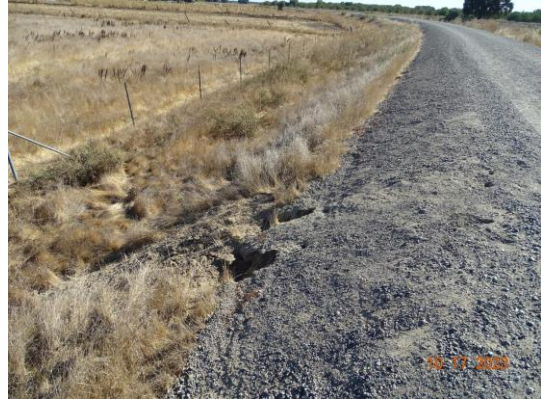
Photo 1 of 1 : FA_2023_NA0017_151_152_20231101_00360.jpg

LM Start	7.29	Rating **	U	Issue No.	152
LM End	7.29	Issue Type +	Ma	Location *	LS
Category	Earthen Levee			GPS Latitude/Longitude	
				Start	End
Item	Animal Control			38.064991°	38.064991°
				-121.251797°	-121.251797°
DWR ID	DWR_NA0017_07_f_2023_152				
Comment Code					
A3 : No rodents visible, but rodent burrows visible; need to backfill and compact or grout burrows.					
Inspector Comment

View of animal burrows along the landside slope. Fall 2023

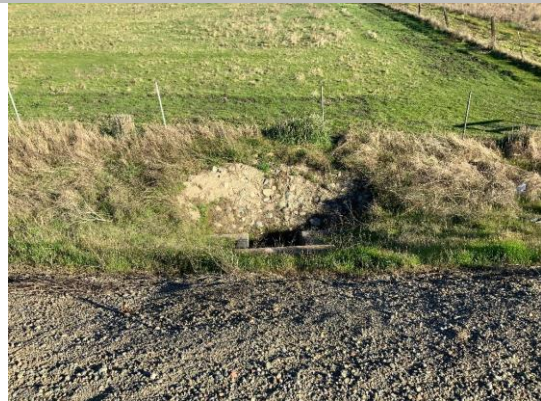
Photo 1 of 3 : UCIP_FA_2023_78952_91896.jpg

Comment Code						
Inspector Comment						
DS_ID:23564 FS_ID:78952 EP_NO: N/A Repair Type: Non-Urgent EVAL Issue: Crossing Status: Found UCIP Comments: 02/24/2021 The record has been upgraded from No Action Needed to Non-Urgent. DWR DMP has not found internal issues, LOF between 1 and 2. Recommend inspection in 5 years. No permit was found authorizing this encroachment. CVFPB will need to review crossing to determine owner. The UCIP inspection was completed with GEI staff, B. Singh. (H. Dunn – GEI) FIELD_STRUCT_DESC: 24-inch corrugated metal storm drainage pipe (CMP) through the levee, 7.5 feet below the crown. Concrete U-shaped headwalls on both ends. Flap gate on the waterside (WS) end. Cobble grouted outlet across the berm. Cobble grouted apron on the landside (LS) end. [Additional Reference(s): DWR Levee Log, 1987, (HLM 7.72). USACE San Joaquin O&M Manual 612.2, 1967, (HLM 7.72), 24-inch pipe listed]. FS Date: 2/24/2021

LS view: LS headwall at toe from crown.

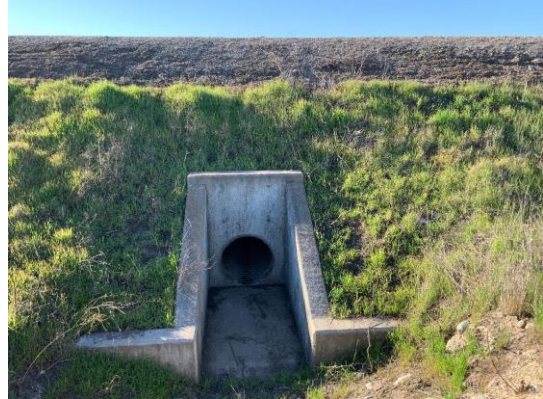
Photo 2 of 3 : UCIP_FA_2023_78952_91897.jpg

LS view: LS headwall at toe.

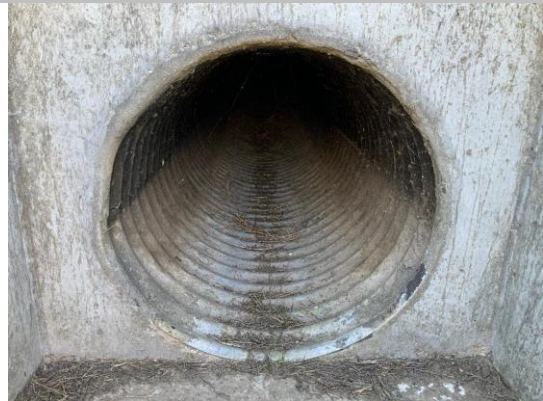
Photo 3 of 3 : UCIP_FA_2023_78952_91898.jpg

LS view: LS pipe.

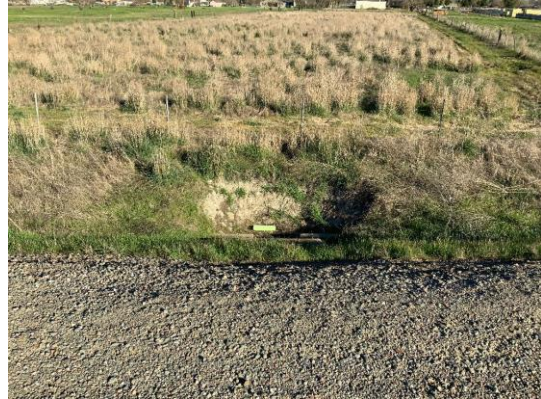
Photo 1 of 3 : UCIP_FA_2023_78953_91904.jpg

Comment Code					
Inspector Comment					
DS_ID:23565 FS_ID:78953 EP_NO: N/A Repair Type: No Action Needed EVAL Issue: Crossing Status: Found UCIP Comments: 09/18/2023 Record updated from Non-Urgent to No Action Needed. Pipe was CIPP lined. DMP internal video inspection has found none or minor pipe defects. Recommend next video inspection in 5 years. (O. Yakimov - DWR UCIP) 02/24/2021 The record has been upgraded from No Action Needed to Non-Urgent. DWR DMP has found integrity issues, LOF between 4 and 5. Crossing will be monitored until funding becomes available for rehabilitation. No permit was found authorizing this encroachment. CVFPB will need to review crossing to determine owner. The UCIP inspection was completed with GEI staff, B. Singh. (H. Dunn – GEI) FIELD_STRUCT_DESC: 24-inch CIPP-lined corrugated metal storm drainage pipe (CMP) through the levee, 7.0 feet below the crown. Concrete U-shaped headwalls on both ends. Flap gate on the waterside (WS) end. Cobble grouted outlet across the berm. Cobble grouted apron on the landside (LS) end. [Additional Reference(s): DWR Levee Log, 1987, (HLM 7.75). USACE San Joaquin O&M Manual 612.2, 1967, (HLM 7.75), 24-inch pipe listed]. FS Date: 2/24/2021

LS headwall at toe from crown.

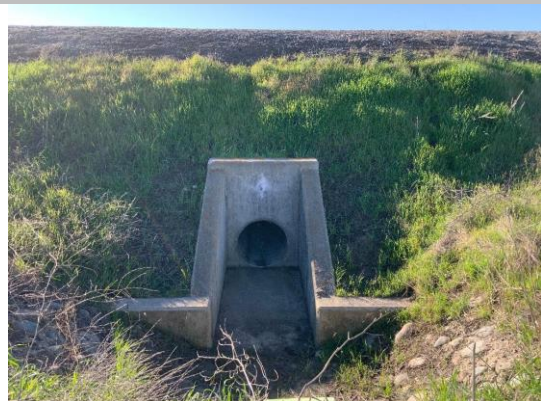
Photo 2 of 3 : UCIP_FA_2023_78953_91905.jpg

LS headwall at toe.

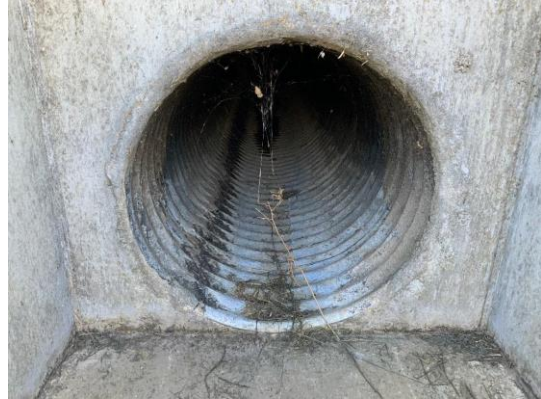
Photo 3 of 3 : UCIP_FA_2023_78953_91906.jpg

LS pipe.

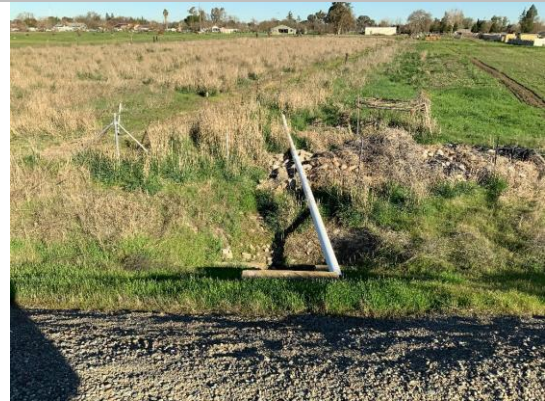
Photo 1 of 3 : UCIP_FA_2023_78954_91912.jpg

Comment Code						
Inspector Comment						
DS_ID:23566 FS_ID:78954 EP_NO: N/A Repair Type: No Action Needed EVAL Issue: Crossing Status: Found UCIP Comments: 09/18/2023 Record updated from Non-Urgent to No Action Needed. Pipe was CIPP lined. DMP internal video inspection has found none or minor pipe defects. Recommend next video inspection in 5 years. (O. Yakimov - DWR UCIP) 02/24/2021 The record has been upgraded from No Action Needed to Non-Urgent. DWR DMP has found integrity issues, LOF between 4 and 5. Crossing will be monitored until funding becomes available for rehabilitation. No permit was found authorizing this encroachment. CVFPB will need to review crossing to determine owner. Small plastic pipe that was previously laying inside drainage pipe is now laying outside adjacent to headwall. The UCIP inspection was completed with GEI staff, B. Singh. (H. Dunn – GEI) FIELD_STRUCT_DESC: 24-inch CIPP-lined corrugated metal storm drainage pipe (CMP) through the levee, 7.0 feet below the crown. Concrete U-shaped headwalls on both ends. Flap gate on the waterside (WS) end. Cobble grouted outlet across the berm. Cobble grouted apron on the landside (LS) end. [Additional Reference(s): DWR Levee Log, 1987, (HLM 7.76). USACE San Joaquin O&M Manual 612.2, 1967, (HLM 7.76), and 612 (addendum), February 1999, (HLM 7.78), (Station 410+54), 24-inch pipe listed]. FS Date: 2/24/2021

LS headwall at toe from crown.

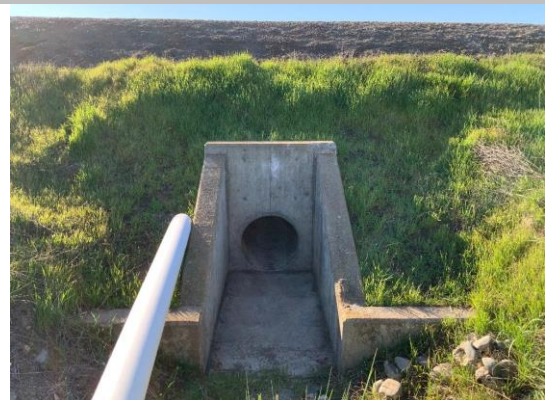
Photo 2 of 3 : UCIP_FA_2023_78954_91913.jpg

LS headwall at toe.

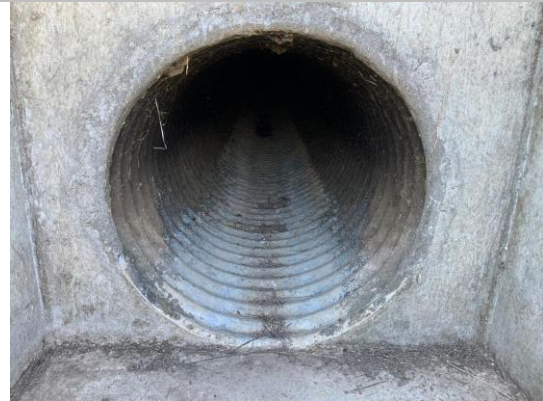
Photo 3 of 3 : UCIP_FA_2023_78954_91914.jpg

LS pipe.

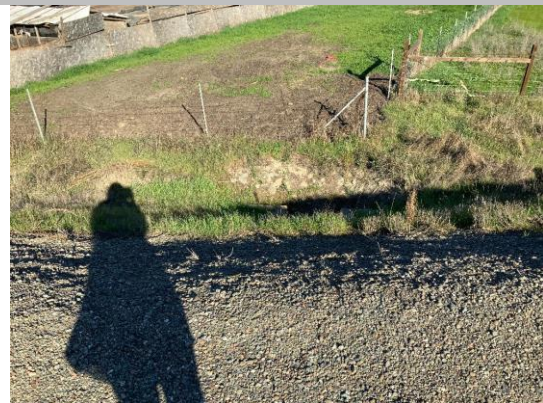
Photo 1 of 3 : UCIP_FA_2023_78955_91921.jpg

Comment Code						
Inspector Comment						
DS_ID:23567 FS_ID:78955 EP_NO: N/A Repair Type: Non-Urgent EVAL Issue: Crossing Status: Found UCIP Comments: 12/20/2022 Record updated from Urgent to Non-Urgent. Pipe has been CIPP lined. LOF of crossing is less or equal to 4. Recommend next video inspection in 5 years. (O.Yakimov - DWR UCIP) 02/24/2021 The record has been upgraded from No Action Needed to Urgent. Significant peeling of metal inside LS pipe. DWR DMP has found integrity issues, LOF between 5 and 6. Crossing will be monitored until funding becomes available to address the issues. No permit was found authorizing this encroachment. CVFPB will need to review crossing to determine owner. The UCIP inspection was completed with GEI staff, B. Singh. (H. Dunn – GEI) FIELD_STRUCT_DESC: 24-inch CIPP-lined corrugated metal storm drainage pipe (CMP) through the levee, 7.0 feet below the crown. Concrete U-shaped headwalls on both ends. Flap gate on the waterside (WS) end. Cobble grouted outlet across the berm. Cobble grouted apron on the landside (LS) end. [Additional Reference(s): DWR Levee Log, 1987, (HLM 7.99). USACE San Joaquin O&M Manual 612.2, 1967, (HLM 7.99), and 612 (addendum), February 1999, (HLM 7.94), (Station 419+06), 24-inch pipe listed]. FS Date: 2/24/2021 11:37:37 AM

LS view: LS headwall at toe from crown.

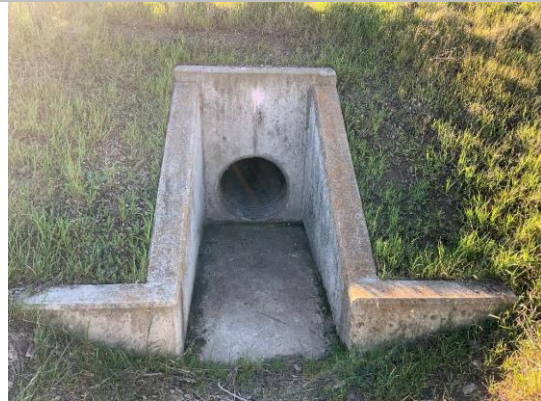
Photo 2 of 3 : UCIP_FA_2023_78955_91922.jpg

LS view: LS headwall at toe.

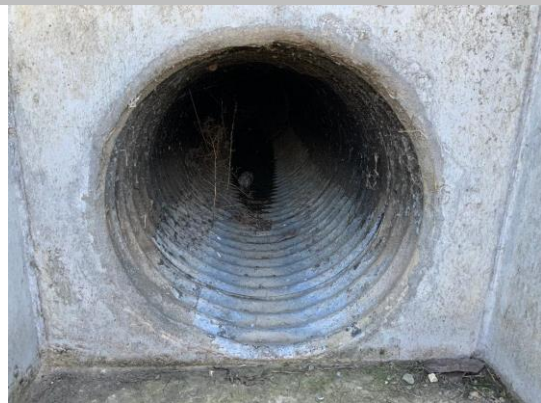
Photo 3 of 3 : UCIP_FA_2023_78955_91915.jpg

LS view: LS pipe.

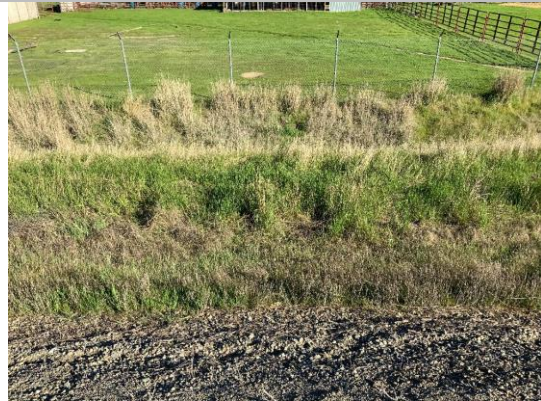
Photo 1 of 3 : UCIP_FA_2023_78330_91925.jpg

Comment Code						
Inspector Comment						
DS_ID:23663 FS_ID:78330 EP_NO: N/A Repair Type: Non-Urgent EVAL Issue: Crossing Status: Not Found UCIP Comments: 02/24/2021 The record has been upgraded from No Action Needed to Non-Urgent. Pipe not found by visual inspection. DWR DMP geophysical study did not confirm presence of pipe through levee. Record will remain in UCIP's inspection records until future Levee Improvement Project can confirm no crossing was found through the levee. No permit was found authorizing this encroachment. CVFPB will need to review crossing to determine owner. The UCIP inspection was completed with GEI staff, B. Singh. (H. Dunn – GEI) FIELD_STRUCT_DESC: 24-inch storm drainage pipe of an unknown material through the levee, at an unknown depth. [Additional Reference(s): USACE San Joaquin O&M Manual 612 (addendum), February 1999, (HLM 8.14), (Station 429+90), 24-inch pipe listed]. FS Date: 2/24/2021

LS view: LS toe from crown, no pipe visible.

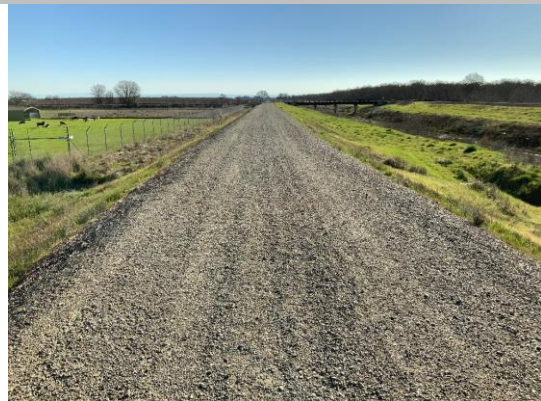
Photo 2 of 3 : UCIP_FA_2023_78330_91923.jpg

Levee crown looking upstream.

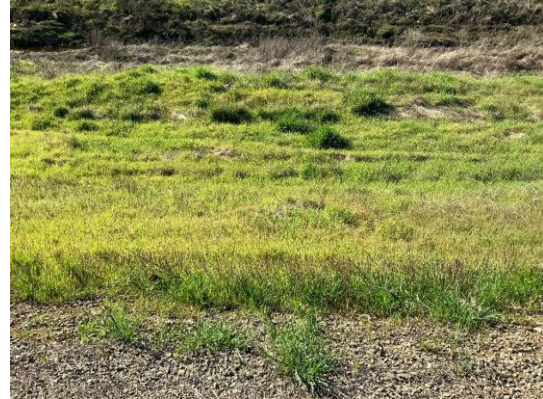
Photo 3 of 3 : UCIP_FA_2023_78330_91924.jpg

WS view: WS toe from crown, no pipe visible.

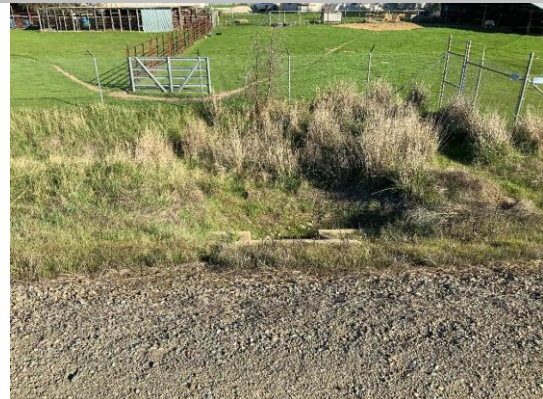
Photo 1 of 3 : UCIP_FA_2023_78899_91930.jpg

DS_ID:23568
FS_ID:78899
EP_NO: N/A
Repair Type: No Action Needed
EVAL Issue:
Crossing Status: Found
UCIP Comments: 09/18/2023 Record updated from Non-Urgent to No Action Needed. Pipe was CIPP lined. DMP internal video inspection has found none or minor pipe defects. Recommend next video inspection in 5 years. (O. Yakimov - DWR UCIP)
02/24/2021 The record has been upgraded from No Action Needed to Non-Urgent. Significant peeling of metal inside LS pipe. DWR DMP has found integrity issues, LOF between 4 and 5. Crossing will be monitored until funding becomes available for rehabilitation. No permit was found authorizing this encroachment. CVFPB will need to review crossing to determine owner. The UCIP inspection was completed with GEI staff, B. Singh. (H. Dunn – GEI)
FIELD_STRUCT_DESC: 36-inch CIPP-lined corrugated metal storm drainage pipe (CMP) through the levee, 8.0 feet below the crown. Concrete U-shaped headwalls on both ends. Flap gate on the waterside (WS) end. Cobble grouted outlet across the berm. Cobble grouted apron on the landside (LS) end. [Additional Reference(s): DWR Levee Log, 1987, (HLM 8.15). USACE San Joaquin O&M Manual 612.2, 1967, (HLM 8.15), 36-inch pipe listed].

LS view: LS headwall at toe from crown.

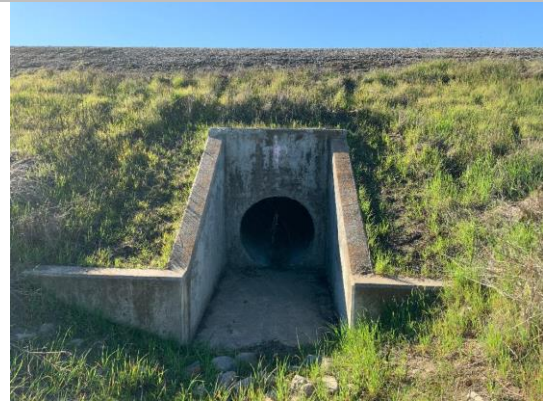
Photo 2 of 3 : UCIP_FA_2023_78899_91931.jpg

LS view: LS headwall at toe.

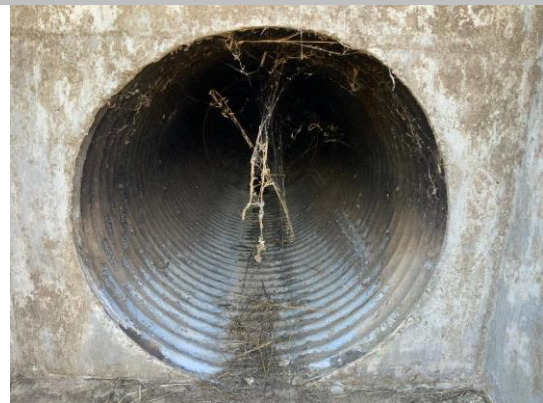
Photo 3 of 3 : UCIP_FA_2023_78899_91932.jpg

LS view: LS pipe.

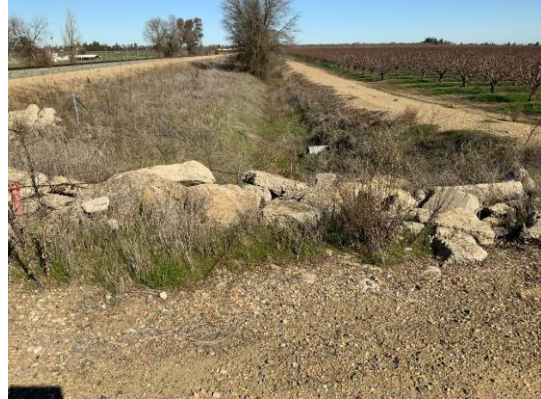
Photo 1 of 3 : UCIP_FA_2023_78900_91942.jpg

Comment Code						
Inspector Comment						
DS_ID:23569 FS_ID:78900 EP_NO: N/A Repair Type: Non-Urgent EVAL Issue: Crossing Status: Found UCIP Comments: 02/24/2021 The record has been upgraded from No Action Needed to Non-Urgent. DWR DMP has not found internal issues, LOF between 1 and 2. Recommend inspection in 5 years. No permit was found authorizing this encroachment. CVFPB will need to review crossing to determine owner. The UCIP inspection was completed with GEI staff, B. Singh. (H. Dunn – GEI) FIELD_STRUCT_DESC: 1 of 2: 36-inch corrugated metal storm drainage pipe (CMP) through the levee, 10.5 feet below the crown. Flap gate on the waterside (WS) end. Slide gate in a 48-inch CMP riser unit on the WS slope. Concrete U-shaped headwalls on both ends. Cobble grouted outlet on the bank. Cobble grouted apron on the landside (LS) end. [Additional Reference(s): DWR Levee Log, 1987, (HLM 8.28). USACE San Joaquin O&M Manual 612.2, 1967, (HLM 8.28), 36-inch pipe listed]. FS Date: 2/24/2021

LS view: LS headwall at toe from crown.

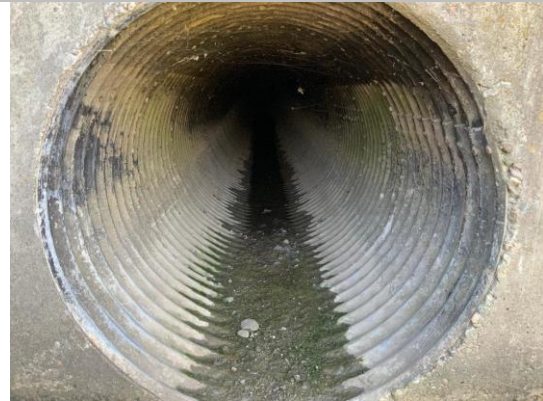
Photo 3 of 3 : UCIP_FA_2023_78900_91945.jpg

LS view: LS pipe.

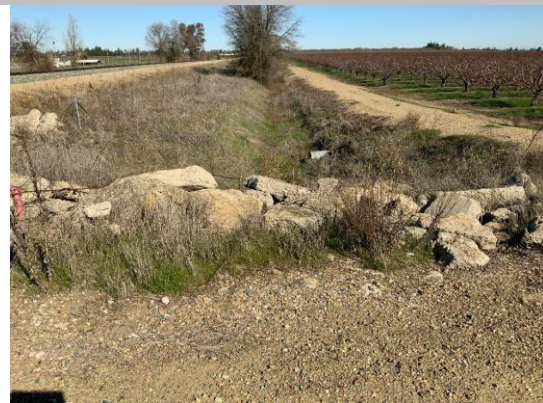
Photo 1 of 3 : UCIP_FA_2023_78901_91952.jpg

DS_ID:23682
 FS_ID:78901
 EP_NO: N/A
 Repair Type: Non-Urgent
 EVAL Issue:
 Crossing Status: Found
 UCIP Comments: 02/24/2021 The record has been upgraded from No Action Needed to Non-Urgent. DWR DMP has not found internal issues, LOF between 1 and 2. Recommend inspection in 5 years. No permit was found authorizing this encroachment. CVFPB will need to review crossing to determine owner. The UCIP inspection was completed with GEI staff, B. Singh. (H. Dunn – GEI)
 FIELD_STRUCT_DESC: 2 of 2: 36-inch corrugated metal storm drainage pipe (CMP) through the levee, 10.5 feet below the crown. Flap gate on the waterside (WS) end. Slide gate in a 48-inch CMP riser unit on the WS slope. Concrete U-shaped headwalls on both ends. Cobble grouted outlet on the bank. Cobble grouted apron on the landside (LS) end. [Additional Reference(s): DWR Levee Log, 1987, (HLM 8.28). USACE San Joaquin O&M Manual 612.2, 1967, (HLM 8.28), 36-inch pipe listed].

LS headwall at toe from crown.

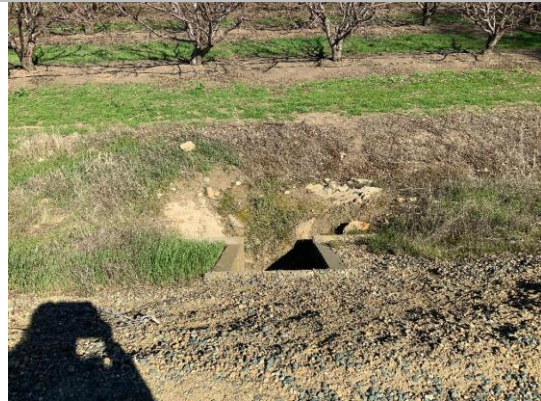
Photo 1 of 3 : UCIP_FA_2023_78902_91962.jpg

Comment Code						
Inspector Comment						
DS_ID:23570 FS_ID:78902 EP_NO: N/A Repair Type: Non-Urgent EVAL Issue: 5, Pipe Damage Crossing Status: Found UCIP Comments: 02/24/2021 The record has been upgraded from No Action Needed to Non-Urgent. DWR DMP has found integrity issues, LOF between 4 and 5. Crossing will be monitored until funding becomes available for rehabilitation. No permit was found authorizing this encroachment. CVFPB will need to review crossing to determine owner. The UCIP inspection was completed with GEI staff, B. Singh. (H. Dunn – GEI) FIELD_STRUCT_DESC: 24-inch corrugated metal storm drainage pipe (CMP) through the levee, 6.5 feet below the crown. Flap gate on the waterside (WS) end. Concrete U-shaped headwalls on both ends. Cobble grouted outlet across the berm. Cobble grouted apron on the landside (LS) end. [Additional Reference(s): DWR Levee Log, 1987, (HLM 8.49). USACE San Joaquin O&M Manual 612.2, 1967, (HLM 8.49), and 612 (addendum), February 1999, (HLM 8.41), (Station 444+00), 24-inch pipe listed]. FS Date: 2/24/2021

LS headwall at toe from crown.

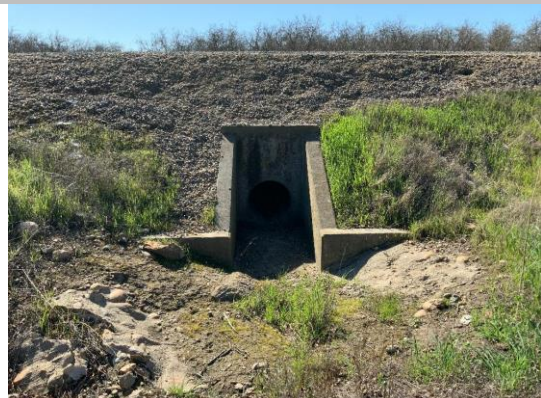
Photo 2 of 3 : UCIP_FA_2023_78902_91963.jpg

LS headwall at toe.

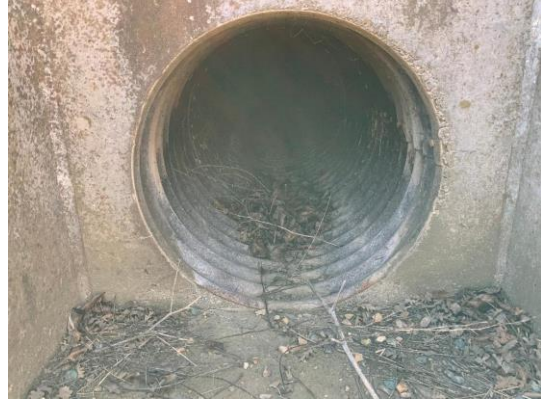
Photo 3 of 3 : UCIP_FA_2023_78902_91964.jpg

LS pipe.

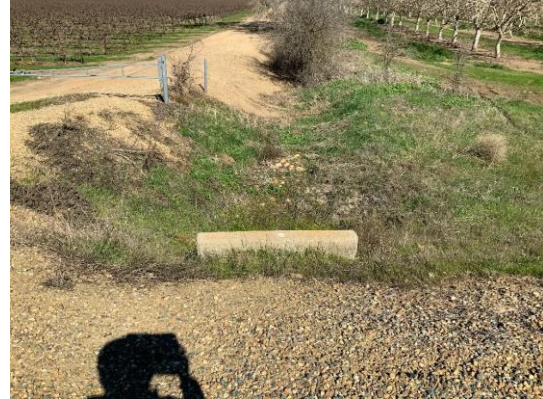
Photo 1 of 3 : UCIP_FA_2023_79415_91987.jpg

Comment Code					
Inspector Comment					
DS_ID:23572 FS_ID:79415 EP_NO: N/A Repair Type: Non-Urgent EVAL Issue: 5, Pipe Damage Crossing Status: Found UCIP Comments: 03/31/2023 Record updated from Urgent to Non-Urgent. LoF is equal to 5.1 due to a small offset joint likely without soil migration, other integrity issues were not found. Crossing will be monitored until funding becomes available for rehabilitation. (O.Yakimov - DWR UCIP). 02/24/2021 The record has been upgraded from Non-Urgent to Urgent. Significant peeling of metal and gap inside of LS pipe. DWR DMP has found integrity issues, LOF between 5 and 6. Crossing will be monitored until funding becomes available to address the issues. No permit was found authorizing this encroachment. CVFPB will need to review crossing to determine owner. The UCIP inspection was completed with GEI staff, B. Singh. (H. Dunn ? GEI) 05/14/2014 A gap at the joint between pipe sections was noted inside pipe at LS toe. This may indicate a need for further maintenance. (W. Wylie -DWR UCIP) FIELD_STRUCT_DESC: 36-inch corrugated metal storm drainage pipe (CMP) through the levee, 7.0 feet below the crown. Flap gate on the waterside (WS) end. Concrete U-shaped headwalls on both ends. Cobble grouted outlet across the berm. Cobble grouted apron on the landside (LS) end. [Additional Reference(s): DWR Levee Log, 1987, (HLM 8.77). USACE San Joaquin O&M Manual 612.2, 1967, (HLM 8.77), 36-inch pipe listed]. FS Date: 2/24/2021

LS view: LS headwall at toe from crown.

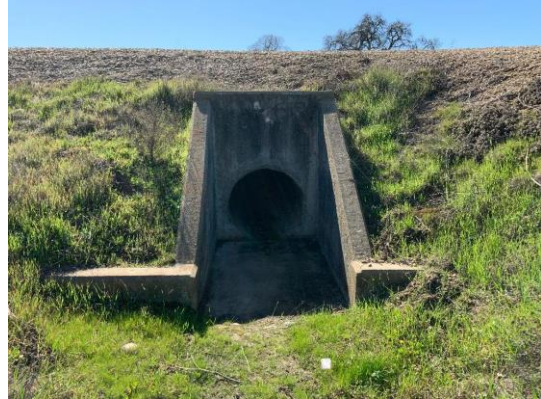
Photo 2 of 3 : UCIP_FA_2023_79415_91988.jpg

LS view: LS headwall at toe.

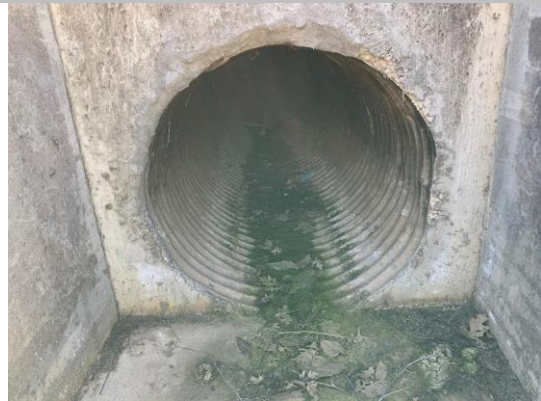
Photo 3 of 3 : UCIP_FA_2023_79415_91989.jpg

LS view: LS pipe.

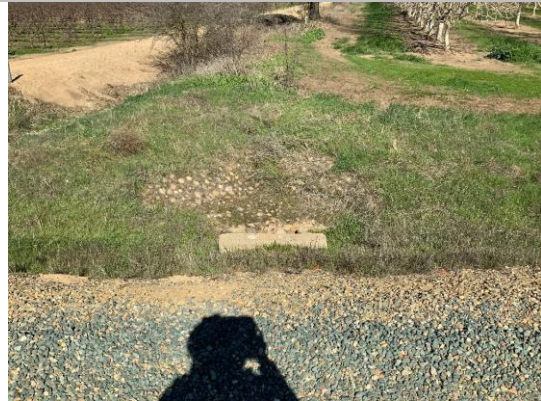
Photo 1 of 3 : UCIP_FA_2023_78957_91996.jpg

Comment Code					
Inspector Comment					
DS_ID:23573 FS_ID:78957 EP_NO: N/A Repair Type: Non-Urgent EVAL Issue: 5, Pipe Damage Crossing Status: Found UCIP Comments: 02/24/2021 Pipe status is still Non-Urgent. Significant peeling of metal inside LS pipe in multiple spots. DWR DMP has found integrity issues, LOF between 4 and 5. Crossing will be monitored until funding becomes available for rehabilitation. No permit was found authorizing this encroachment. No permit was found authorizing this encroachment. CVFPB will need to review crossing to determine owner. The UCIP inspection was completed with GEI staff, B. Singh. (H. Dunn – GEI) FIELD_STRUCT_DESC: 24-inch corrugated metal storm drainage pipe (CMP) through the levee, 6.5 feet below the crown. Flap gate on the waterside (WS) end. Concrete U-shaped headwalls on both ends. Cobble grouted outlet across the berm. Cobble grouted apron on the landside (LS) end. [Additional Reference(s): DWR Levee Log, 1987, (HLM 8.77). USACE San Joaquin O&M Manual 612.2, 1967, (HLM 8.78), 24-inch pipe listed]. FS Date: 2/24/2021

LS view: LS headwall at toe from crown.

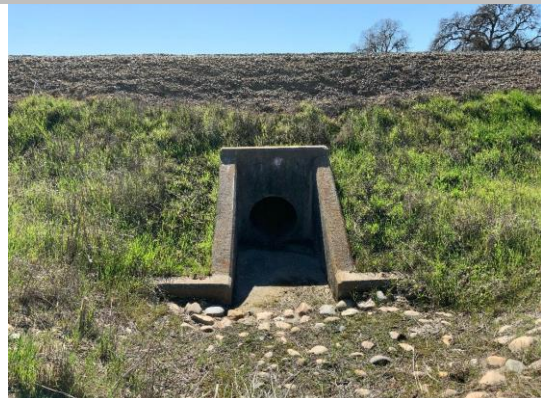
Photo 2 of 3 : UCIP_FA_2023_78957_91997.jpg

LS view: LS headwall at toe.

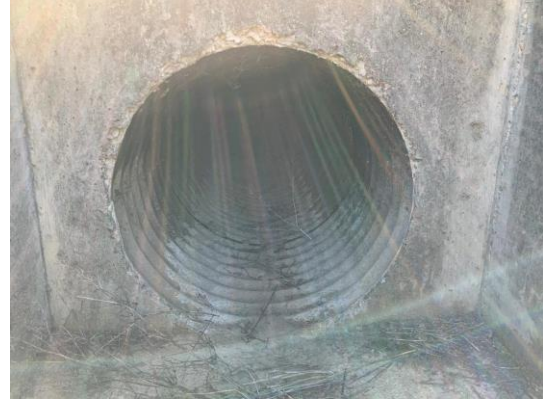
Photo 3 of 3 : UCIP_FA_2023_78957_91998.jpg

LS view: LS pipe.

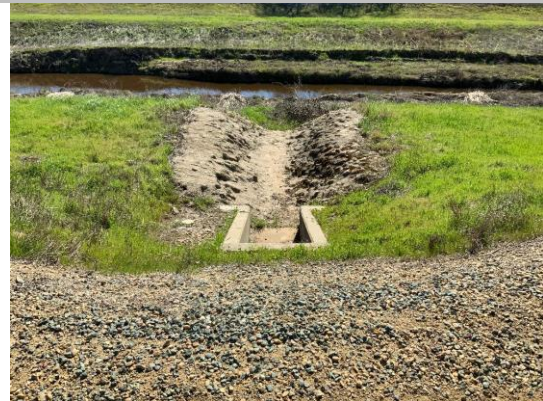
Photo 1 of 3 : UCIP_FA_2023_78958_92004.jpg

DS_ID:23574
 FS_ID:78958
 EP_NO: N/A
 Repair Type: Non-Urgent
 EVAL Issue: 5, Pipe Damage
 Crossing Status: Found
 UCIP Comments: 02/24/2021 The record has been upgraded from No Action Needed to Non-Urgent. DWR DMP has found integrity issues, LOF between 4 and 5. Crossing will be monitored until funding becomes available for rehabilitation. No permit was found authorizing this encroachment. CVFPB will need to review crossing to determine owner. The UCIP inspection was completed with GEI staff, B. Singh. (H. Dunn – GEI)
 FIELD_STRUCT_DESC: 24-inch corrugated metal storm drainage pipe (CMP) through the levee, 7.0 feet below the crown. Flap gate on the waterside (WS) end. Concrete U-shaped headwalls on both ends. Cobble grouted outlet across the berm. [Additional Reference(s): DWR Levee Log, 1987, (HLM 8.97). USACE San Joaquin O&M Manual 612.2, 1967, (HLM 8.97), and 612 (addendum), February 1999, (HLM 8.90), (Station 469+82), 24-inch pipe listed].

WS view: WS headwall at toe.

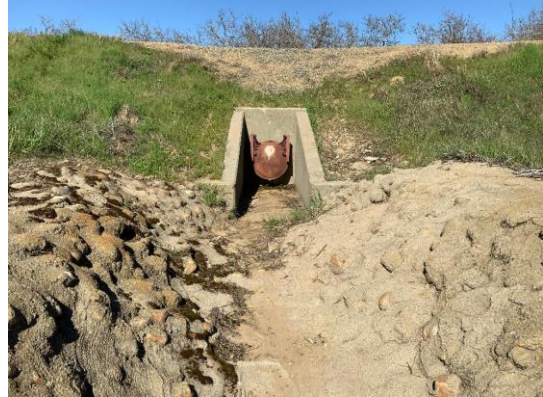
Photo 2 of 3 : UCIP_FA_2023_78958_92005.jpg

WS view: WS headwall and flapgate at toe.

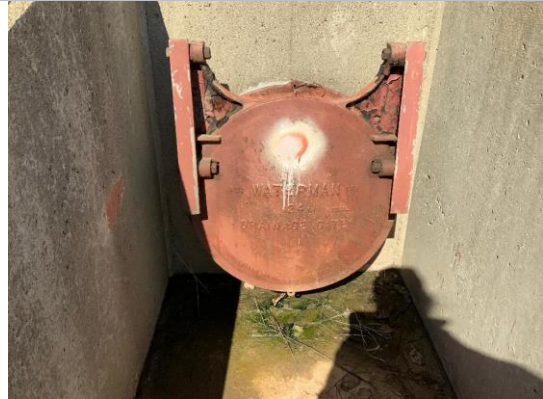
Photo 3 of 3 : UCIP_FA_2023_78958_92006.jpg

WS view: WS flapgate.

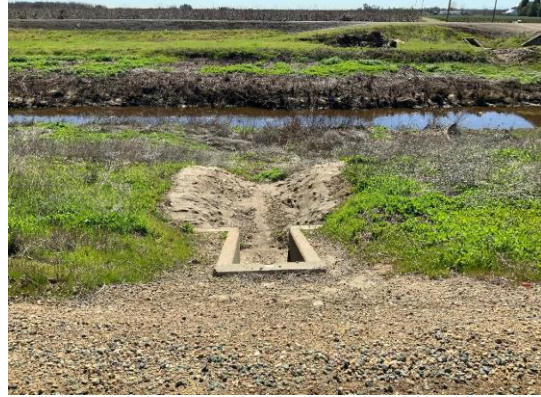
Photo 1 of 3 : UCIP_FA_2023_78906_92009.jpg

Comment Code						
Inspector Comment						
DS_ID:23576 FS_ID:78906 EP_NO: N/A Repair Type: Non-Urgent EVAL Issue: 5, Pipe Damage Crossing Status: Found UCIP Comments: 02/24/2021 The record has been upgraded from No Action Needed to Non-Urgent. DWR DMP has found integrity issues, LOF between 4 and 5. Crossing will be monitored until funding becomes available for rehabilitation. Minor flaking off of concrete on the inside edge of LS headwall. No permit was found authorizing this encroachment. CVFPB will need to review crossing to determine owner. The UCIP inspection was completed with GEI staff, B. Singh. (H. Dunn – GEI) FIELD_STRUCT_DESC: 24-inch corrugated metal storm drainage pipe (CMP) through the levee, 6.5 feet below the crown. Flap gate on the waterside (WS) end. Concrete U-shaped headwalls on both ends. Cobble grouted outlet across the berm. Cobble grouted apron on the landside (LS) end. [Additional Reference(s): DWR Levee Log, 1987, (HLM 9.18). USACE San Joaquin O&M Manual 612.2, 1967, (HLM 9.17), and 612 (addendum), February 1999, (HLM 9.17), (Station 484+30), 24-inch pipe listed]. FS Date: 2/24/2021

WS view: WS headwall at toe from crown.

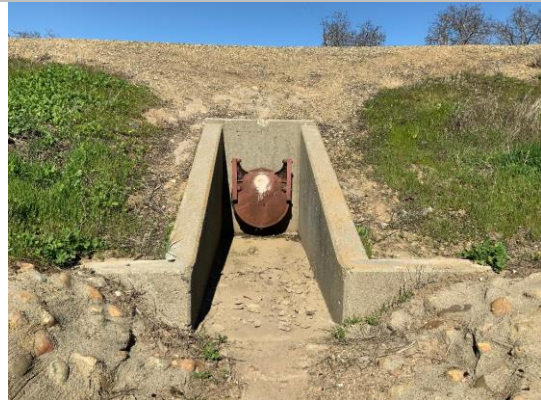
Photo 2 of 3 : UCIP_FA_2023_78906_92010.jpg

WS view: WS headwall and flapgate at toe.

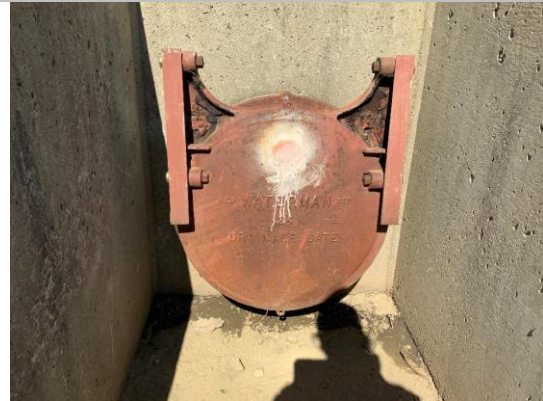
Photo 3 of 3 : UCIP_FA_2023_78906_92012.jpg

WS view: WS flapgate.

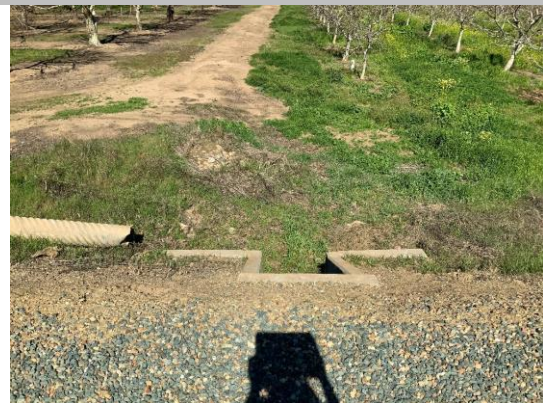
Photo 1 of 3 : UCIP_FA_2023_78959_92030.jpg

DS_ID:23578
 FS_ID:78959
 EP_NO: N/A
 Repair Type: Non-Urgent
 EVAL Issue:
 Crossing Status: Found
 UCIP Comments: 02/24/2021 The record has been upgraded from No Action Needed to Non-Urgent. DWR DMP has not found internal issues, LOF between 1 and 2. Recommend inspection in 5 years. No permit was found authorizing this encroachment. CVFPB will need to review crossing to determine owner. The UCIP inspection was completed with GEI staff, B. Singh. (H. Dunn – GEI)
 FIELD_STRUCT_DESC: 24-inch corrugated metal storm drainage pipe (CMP) through the levee, 8.0 feet below the crown. Flap gate on the waterside (WS) end. Concrete U-shaped headwalls on both ends. Cobble grouted outlet across the berm. Cobble grouted apron on the landside (LS) end. [Additional Reference(s): DWR Levee Log, 1987, (HLM 9.41). USACE San Joaquin O&M Manual 612.2, 1967, (HLM 9.41), and 612 (addendum), February 1999, (HLM 9.37), (Station 494+50), 24-inch pipe listed].

LS view: LS headwall at toe from crown.

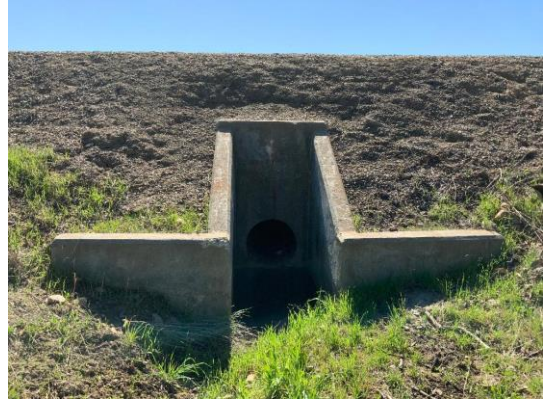
Photo 2 of 3 : UCIP_FA_2023_78959_92029.jpg

LS view: LS headwall at toe.

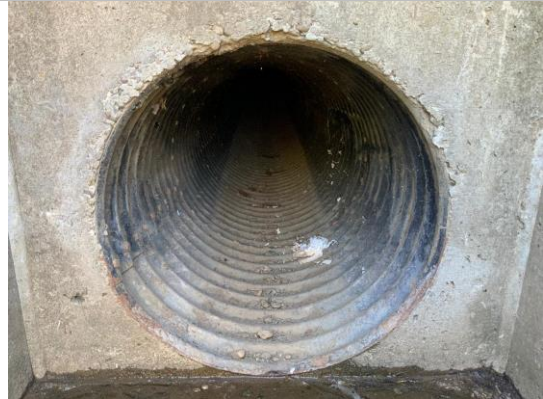
Photo 3 of 3 : UCIP_FA_2023_78959_92028.jpg

LS view: LS pipe.

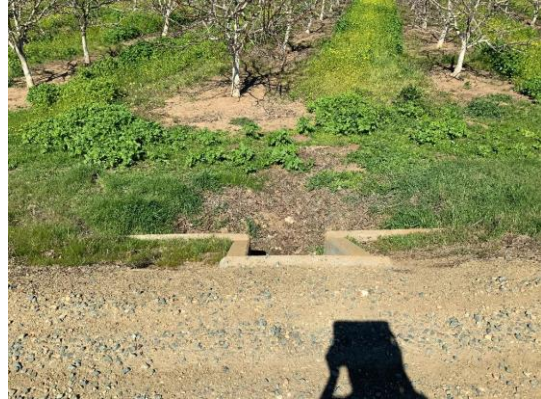
Photo 1 of 3 : UCIP_FA_2023_78960_92040.jpg

Comment Code						
Inspector Comment						
DS_ID:23580 FS_ID:78960 EP_NO: N/A Repair Type: Non-Urgent EVAL Issue: 5, Pipe Damage Crossing Status: Found UCIP Comments: 02/24/2021 The record has been upgraded from No Action Needed to Non-Urgent. DWR DMP has found integrity issues, LOF between 4 and 5. Crossing will be monitored until funding becomes available for rehabilitation. No permit was found authorizing this encroachment. CVFPB will need to review crossing to determine owner. The UCIP inspection was completed with GEI staff, B. Singh. (H. Dunn – GEI) FIELD_STRUCT_DESC: 24-inch corrugated metal storm drainage pipe (CMP) through the levee, 6.5 feet below the crown. Flap gate on the waterside (WS) end. Concrete U-shaped headwalls on both ends. Cobble grouted outlet and apron. [Additional Reference(s): DWR Levee Log, 1987, (HLM 9.56). USACE San Joaquin O&M Manual 612.2, 1967, (HLM 9.56), and 612 (addendum), February 1999, (HLM 9.56), (Station 504+71), 24-inch pipe listed]. FS Date: 2/24/2021

LS headwall at toe from crown.

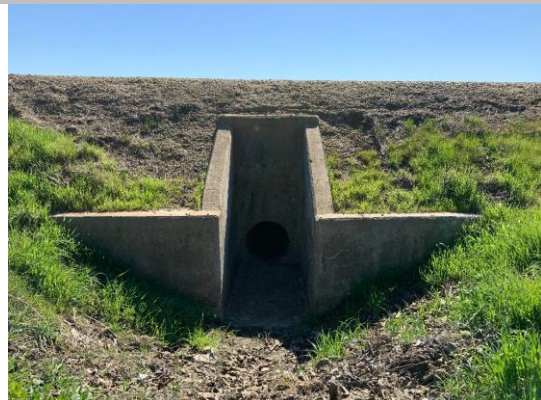
Photo 2 of 3 : UCIP_FA_2023_78960_92041.jpg

LS headwall at toe.

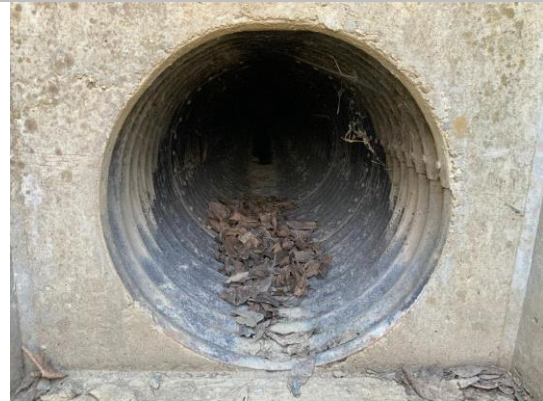
Photo 3 of 3 : UCIP_FA_2023_78960_92042.jpg

LS pipe.

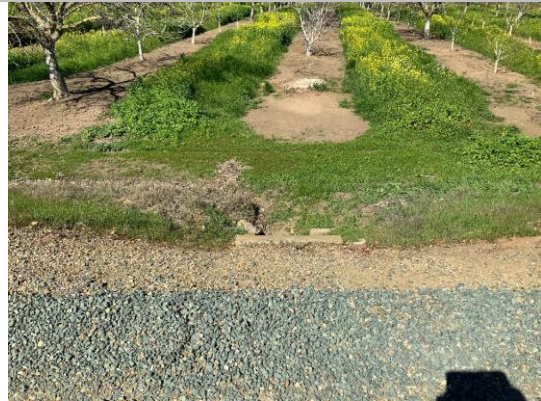
Photo 1 of 3 : UCIP_FA_2023_78909_92058.jpg

Comment Code						
Inspector Comment						
DS_ID:23582						
FS_ID:78909						
EP_NO: N/A						
Repair Type: Non-Urgent						
EVAL Issue: 5, Pipe Damage						
Crossing Status: Found						
UCIP Comments: 02/24/2021 The record has been upgraded from No Action Needed to Non-Urgent. DWR DMP has found integrity issues, LOF between 4 and 5. Crossing will be monitored until funding becomes available for rehabilitation. No permit was found authorizing this encroachment. CVFPB will need to review crossing to determine owner. The UCIP inspection was completed with GEI staff, B. Singh. (H. Dunn – GEI)						
FIELD_STRUCT_DESC: 24-inch corrugated metal storm drainage pipe (CMP) through the levee, 7.5 feet below the crown. Flap gate on the waterside (WS) end. Concrete U-shaped headwalls on both ends. Cobble grouted outlet across the berm. Cobble grouted apron on the WS end. [Additional Reference(s): DWR Levee Log, 1987, (HLM 9.91). USACE San Joaquin O&M Manual 612.2, 1967, (HLM 9.91), 24-inch pipe listed].

LS view: LS headwall at toe from crown.

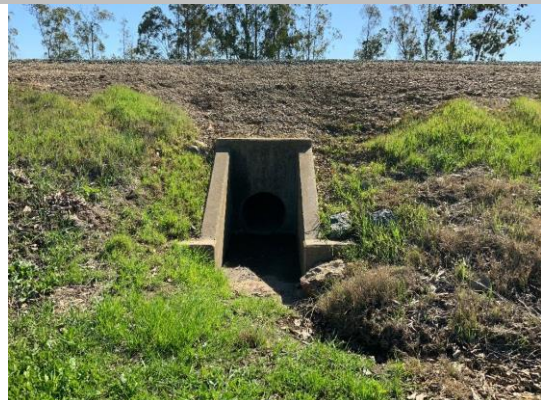
Photo 2 of 3 : UCIP_FA_2023_78909_92059.jpg

LS view: LS headwall at toe.

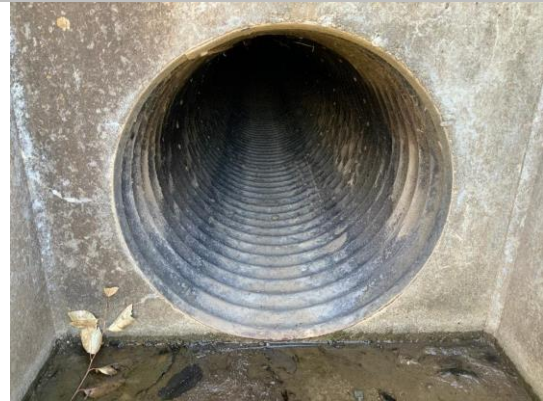
Photo 3 of 3 : UCIP_FA_2023_78909_92060.jpg

LS view: LS pipe.

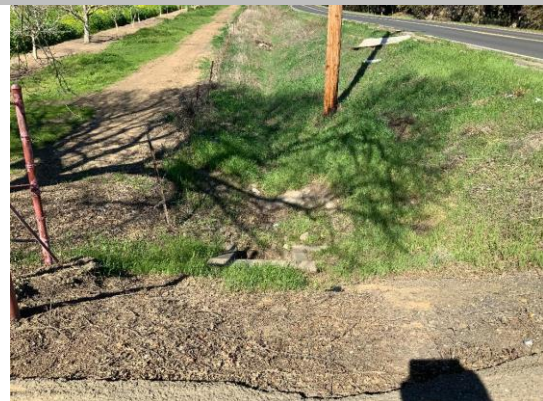
Photo 1 of 3 : UCIP_FA_2023_78910_92065.jpg

DS_ID:23583
 FS_ID:78910
 EP_NO: N/A
 Repair Type: Non-Urgent
 EVAL Issue: 5, Pipe Damage
 Crossing Status: Found
 UCIP Comments: 02/24/2021 The record has been upgraded from No Action Needed to Non-Urgent. DWR DMP has found integrity issues, LOF between 4 and 5. Crossing will be monitored until funding becomes available for rehabilitation. No permit was found authorizing this encroachment. CVFPB will need to review crossing to determine owner. The UCIP inspection was completed with GEI staff, B. Singh. (H. Dunn – GEI)
 FIELD_STRUCT_DESC: 24-inch corrugated metal storm drainage pipe (CMP) through the levee, 10.0 feet below the crown. Flap gate on the waterside (WS) end. Concrete U-shaped headwalls on both ends. Cobble grouted outlet across the berm. Cobble grouted apron on the landside (LS) end. [Additional Reference(s): DWR Levee Log, 1987, (HLM 10.09). USACE San Joaquin O&M Manual 612.2, 1967, (HLM 10.09), and 612 (addendum), February 1999, (HLM 9.94), (Station 524+90), 24-inch pipe listed].

LS view: LS headwall at toe from crown.

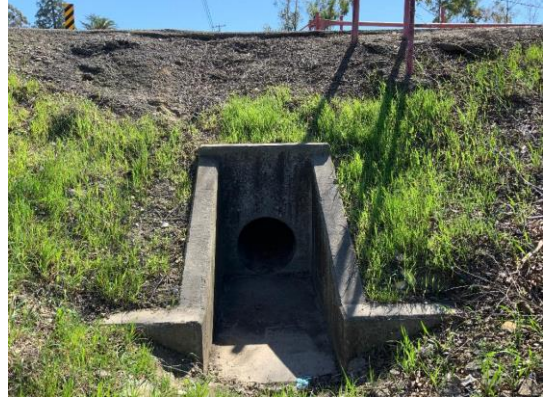
Photo 2 of 3 : UCIP_FA_2023_78910_92066.jpg

LS view: LS headwall at toe.

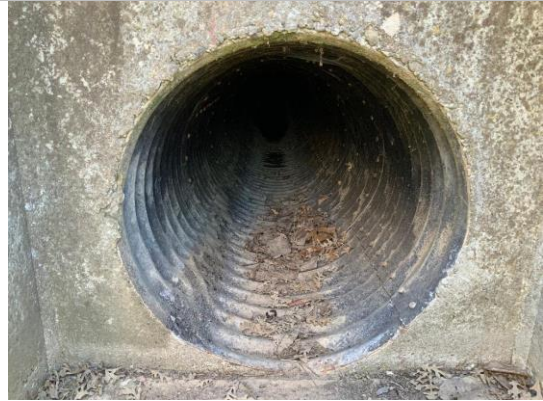
Photo 3 of 3 : UCIP_FA_2023_78910_92067.jpg

LS view: LS pipe.

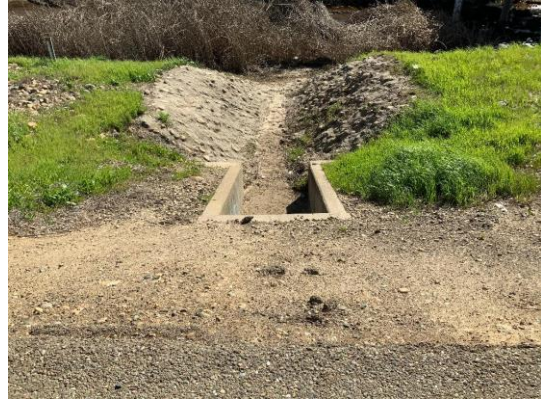
Photo 1 of 3 : UCIP_FA_2023_78961_92077.jpg

Comment Code						
Inspector Comment						
DS_ID:23584 FS_ID:78961 EP_NO: N/A Repair Type: Non-Urgent EVAL Issue: 5, Pipe Damage Crossing Status: Found UCIP Comments: 02/24/2021 The record has been upgraded from No Action Needed to Non-Urgent. DWR DMP has found integrity issues, LOF between 4 and 5. Crossing will be monitored until funding becomes available for rehabilitation. No permit was found authorizing this encroachment. CVFPB will need to review crossing to determine owner. The UCIP inspection was completed with GEI staff, B. Singh. (H. Dunn – GEI) FIELD_STRUCT_DESC: 36-inch corrugated metal storm drainage pipe (CMP) through the levee, 6.0 feet below the crown. Flap gate on the waterside (WS) end. Concrete U-shaped headwalls on both ends. Cobble grouted outlet across the berm. Cobble grouted apron on the landside (LS) end. [Additional Reference(s): DWR Levee Log, 1987, (HLM 10.11). USACE San Joaquin O&M Manual 612.2, 1967, (HLM 10.11), 36-inch pipe listed]. FS Date: 2/24/2021

WS view: WS headwall at toe from crown.

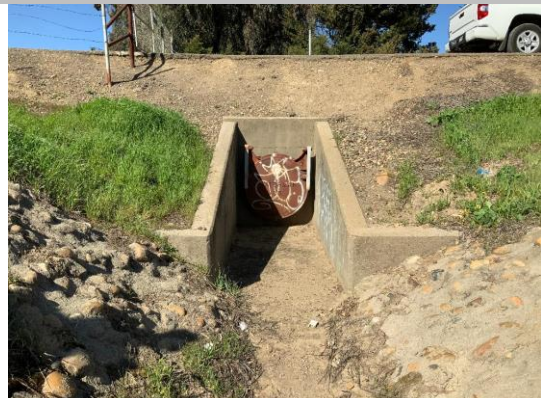
Photo 2 of 3 : UCIP_FA_2023_78961_92078.jpg

WS view: WS headwall and flapgate at toe.

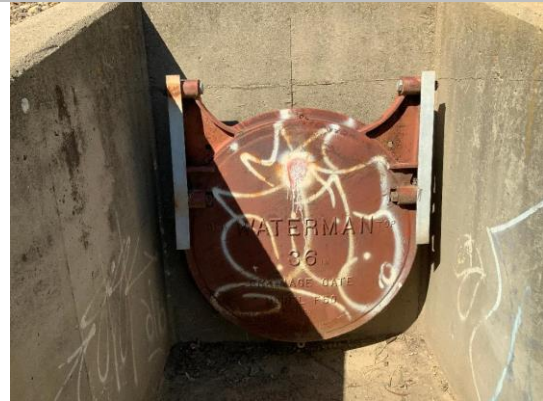
Photo 3 of 3 : UCIP_FA_2023_78961_92079.jpg

WS view: WS flapgate.

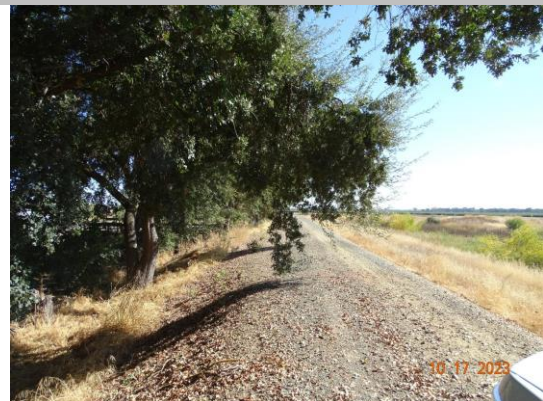
Photo 1 of 1 : FA_2023_NA0017_151_253_20231101_00363.jpg

LM Start	9.71	Rating **	U	Issue No.	253
LM End	9.71	Issue Type +	Ma	Location *	CR
Category	Earthen Levee			GPS Latitude/Longitude	
				Start	End
Item	Trim / Thin Trees			38.074426°	38.074426°
				-121.210807°	-121.210807°
DWR ID	DWR_NA0017_07_f_2022_253				
Comment Code					
T4 : Trim trees over roadway to at least 12 feet above ground level.					
Inspector Comment

View of untrimmed tree over the crown. Fall 2023

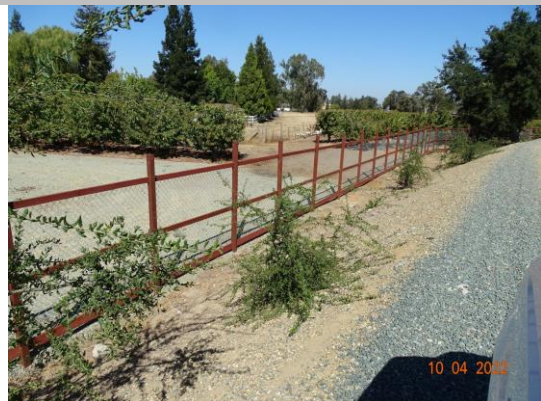
Photo 1 of 1 : FA_2023_NA0017_151_273_20230905_00034.jpg

LM Start	9.93	Rating **	M	Issue No.	273
LM End	10.02	Issue Type +	Ma	Location *	LS
Category	Earthen Levee			GPS Latitude/Longitude	
				Start	End
Item	Vegetation			38.076668°	38.077671°
				-121.208584°	-121.207646°
DWR ID	DWR_NA0017_07_f_2022_273				
Comment Code					
V2 : Remove the wild growth and woody vegetation other than native grasses from the levee slopes.					
Inspector Comment					
Trees are planted along the landside slope.

View of planted trees along the landside slope. Fall 2022

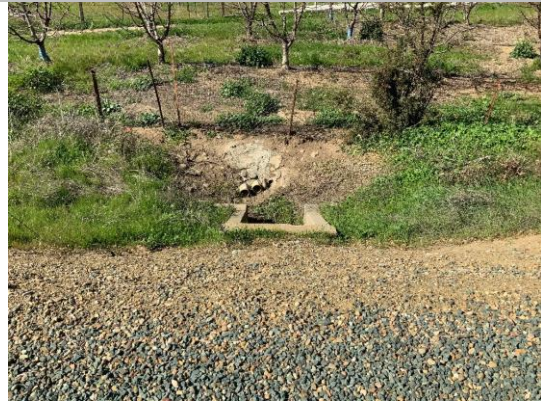
Photo 1 of 3 : UCIP_FA_2023_78962_92096.jpg

Comment Code						
Inspector Comment						
DS_ID:23585 FS_ID:78962 EP_NO: N/A Repair Type: Non-Urgent EVAL Issue: Crossing Status: Found UCIP Comments: 02/24/2021 Pipe status is still Non-Urgent. DWR DMP has not found internal issues, LOF between 1 and 2. Recommend inspection in 5 years. No permit was found authorizing this encroachment. CVFPB will need to review crossing to determine owner. The UCIP inspection was completed with GEI staff, B. Singh. (H. Dunn – GEI) FIELD_STRUCT_DESC: 24-inch corrugated metal storm drainage pipe (CMP) through the levee, 7.5 feet below the crown. Flap gate on the waterside (WS) end. Concrete U-shaped headwalls on both ends. Cobble grouted outlet across the berm. [Additional Reference(s): DWR Levee Log, 1987, (HLM 10.45). USACE San Joaquin O&M Manual 612.2, 1967, (HLM 10.45), and 612 (addendum), February 1999, (HLM 10.46), (Station 552+25), 24-inch pipe listed]. FS Date: 2/24/2021

LS view: LS headwall at toe from crown.

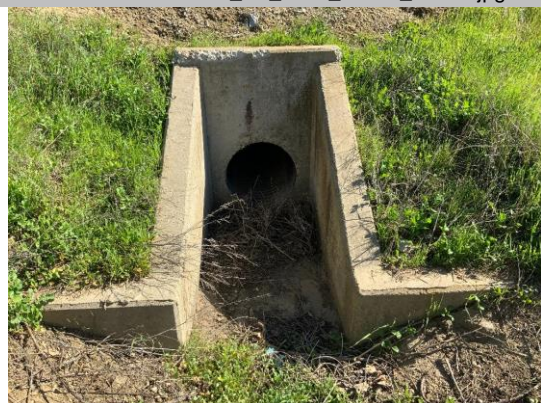
Photo 2 of 3 : UCIP_FA_2023_78962_92097.jpg

LS view: LS headwall at toe.

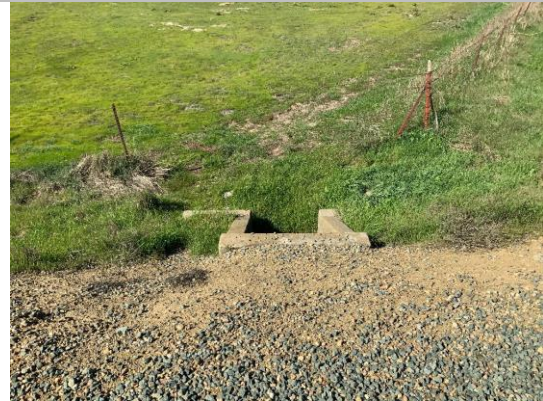
Photo 1 of 3 : UCIP_FA_2023_78963_92108.jpg

Comment Code						
Inspector Comment						
DS_ID:23586 FS_ID:78963 EP_NO: N/A Repair Type: Non-Urgent EVAL Issue: Crossing Status: Found UCIP Comments: 02/24/2021 The record has been upgraded from No Action Needed to Non-Urgent. DWR DMP has not found internal issues, LOF between 1 and 2. Recommend inspection in 5 years. No permit was found authorizing this encroachment. CVFPB will need to review crossing to determine owner. The UCIP inspection was completed with GEI staff, B. Singh. (H. Dunn – GEI) FIELD_STRUCT_DESC: 24-inch corrugated metal storm drainage pipe (CMP) through the levee, 6.0 feet below the crown. Flap gate on the waterside (WS) end. Concrete U-shaped headwalls on both ends. Cobble grouted outlet across the berm. Cobble grouted apron on the landside (LS) end. [Additional Reference(s): DWR Levee Log, 1987, (HLM 10.62). USACE San Joaquin O&M Manual 612.2, 1967, (HLM 10.62), 24-inch pipe listed]. FS Date: 2/24/2021

LS view: LS headwall at toe from crown.

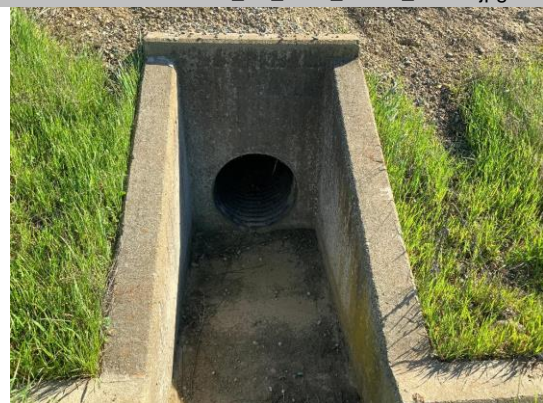
Photo 2 of 3 : UCIP_FA_2023_78963_92109.jpg

LS view: LS headwall at toe.

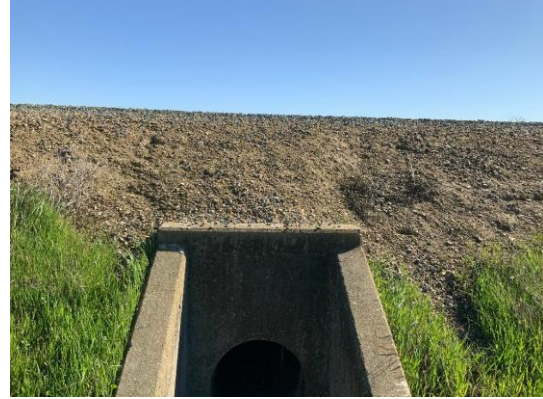
Photo 3 of 3 : UCIP_FA_2023_78963_92110.jpg

LS view: LS headwall at toe.

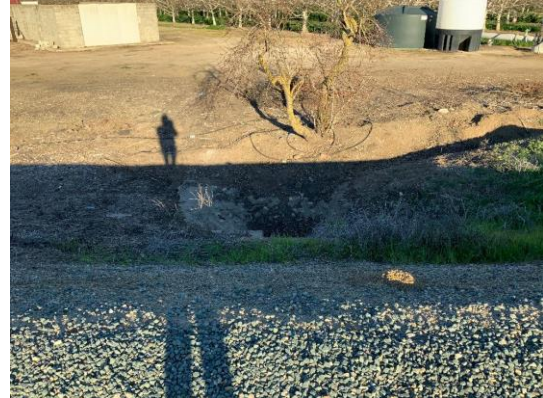
Photo 1 of 3 : UCIP_FA_2023_78964_92115.jpg

DS_ID:23646
 FS_ID:78964
 EP_NO: N/A
 Repair Type: Non-Urgent
 EVAL Issue:
 Crossing Status: Found
 UCIP Comments: 02/25/2021 The record has been upgraded from No Action Needed to Non-Urgent. DWR DMP has not found internal issues, LOF between 1 and 2. Recommend inspection in 5 years. WS flapgate partially covered by vegetation. No permit was found authorizing this encroachment. CVFPB will need to review crossing to determine owner. The UCIP inspection was completed with LMA representative, M. McCoy. (H. Dunn – GEI)
 FIELD_STRUCT_DESC: 24-inch corrugated metal storm drainage pipe (CMP) through the levee, 7.5 feet below the crown. Flap gate on the waterside (WS) end. Concrete U-shaped headwalls on both ends.
 [Additional Reference(s): DWR Levee Log, 1987, (HLM 10.62). USACE San Joaquin O&M Manual 612.2, 1967, (HLM 10.91), and 612 (addendum), February 1999, (HLM 10.80), (Station 570+48), 24-inch pipe listed].

LS view: LS headwall at toe from crown.

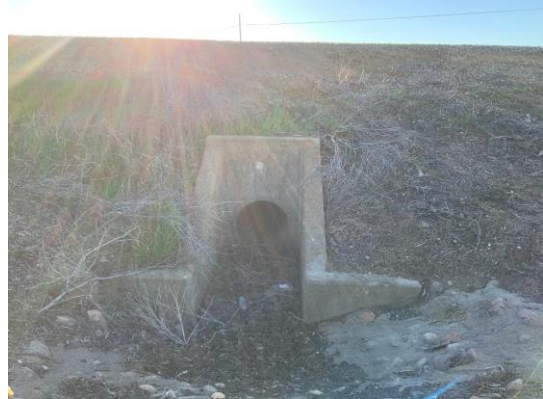
Photo 2 of 3 : UCIP_FA_2023_78964_92116.jpg

LS view: LS headwall at toe.

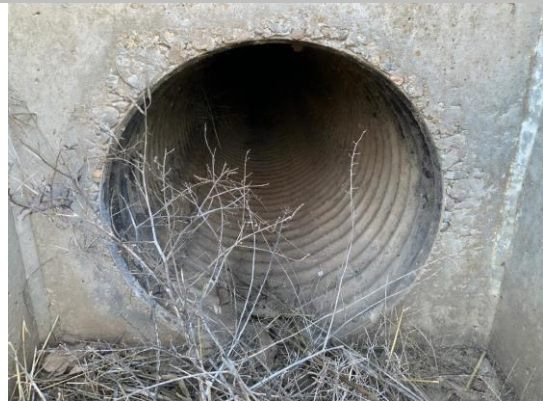
Photo 3 of 3 : UCIP_FA_2023_78964_92117.jpg

LS view: LS pipe.
