**Flood Control Project Maintenance
Levee Inspections**

Maintenance Issue Types Only, Levee Inspection Report By Mile - Fall 2023

San Joaquin County Flood Control and Water Conservation District

Waterway	Bank	Unit Miles	Inspection Start/End	Inspector
Unit No. 01 Littlejohn Creek	Left	2.59	10/20/2023 10/20/2023	Alberto De Leon

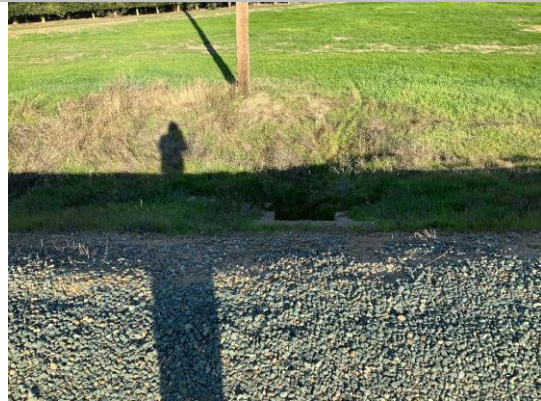
Photo 1 of 3 : UCIP_FA_2023_78965_92127.jpg

Comment Code						
Inspector Comment						
DS_ID:23587						
FS_ID:78965						
EP_NO: N/A						
Repair Type: Non-Urgent						
EVAL Issue:						
Crossing Status: Found						
UCIP Comments: 02/25/2021 Pipe status is still Non-Urgent. DWR						
DMP has not found internal issues, LOF between 1 and 2. Recommend						
inspection in 5 years. No permit was found authorizing this						
encroachment. CVFPB will need to review crossing to determine owner.						
The UCIP inspection was completed with LMA representative, M.						
Mccoy. (H. Dunn – GEI) 05/14/2014 Silt buildup in pipe at LS toe. (W.						
Wylie - DWR UCIP)						
FIELD_STRUCT_DESC: 24-inch corrugated metal storm drainage pipe						
(CMP) through the levee, 6.5 feet below the crown. Flap gate on the						
waterside (WS) end. Concrete U-shaped headwalls on both ends.						
Cobble grouted outlet across the berm. Cobble grouted apron on the						
WS end. [Additional Reference(s): DWR Levee Log, 1987, (HLM 11.14).

LS view: LS headwall at toe from crown.

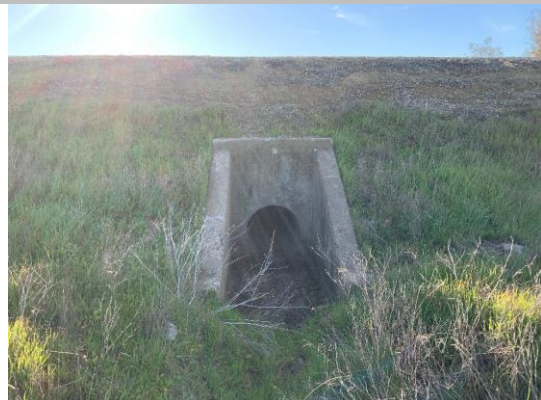
Photo 2 of 3 : UCIP_FA_2023_78965_92128.jpg

LS view: LS headwall at toe.

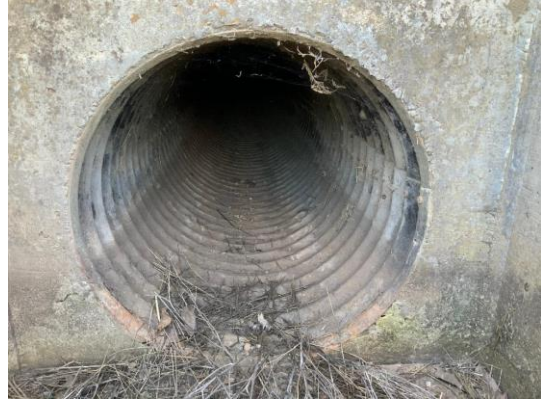
Photo 3 of 3 : UCIP_FA_2023_78965_92129.jpg

LS view: LS pipe.

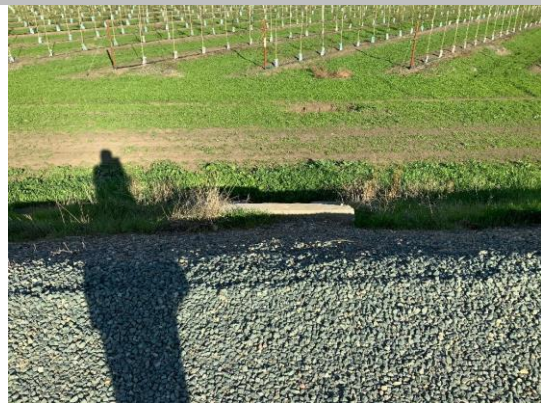
Photo 1 of 3 : UCIP_FA_2023_78966_92134.jpg

DS_ID:23588
 FS_ID:78966
 EP_NO: N/A
 Repair Type: Non-Urgent
 EVAL Issue:
 Crossing Status: Found
 UCIP Comments: 02/25/2021 The record has been upgraded from No Action Needed to Non-Urgent. DWR DMP has not found internal issues, LOF between 1 and 2. Recommend inspection in 5 years. No permit was found authorizing this encroachment. CVFPB will need to review crossing to determine owner. The UCIP inspection was completed with LMA representative, M. McCoy. (H. Dunn – GEI)
 FIELD_STRUCT_DESC: 24-inch corrugated metal storm drainage pipe (CMP) through the levee, 6.5 feet below the crown. Flap gate on the waterside (WS) end. Concrete U-shaped headwalls on both ends. Cobble grouted outlet across the berm. Cobble grouted apron on the landside (LS) end. [Additional Reference(s): DWR Levee Log, 1987, (HLM 11.30). USACE San Joaquin O&M Manual 612.2, 1967, (HLM 11.30), and 612 (addendum), February 1999, (HLM 11.26), (Station 594+46), 24-inch pipe listed].

LS headwall at toe from crown.

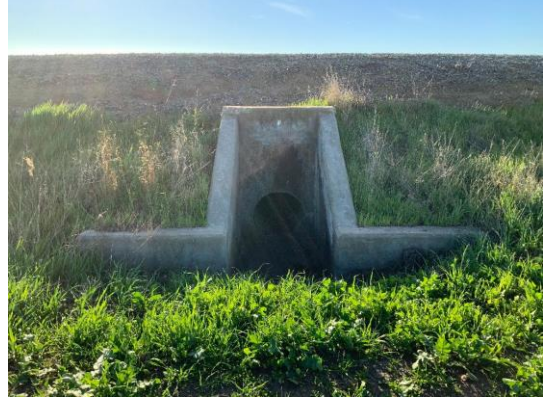
Photo 2 of 3 : UCIP_FA_2023_78966_92135.jpg

LS headwall at toe.

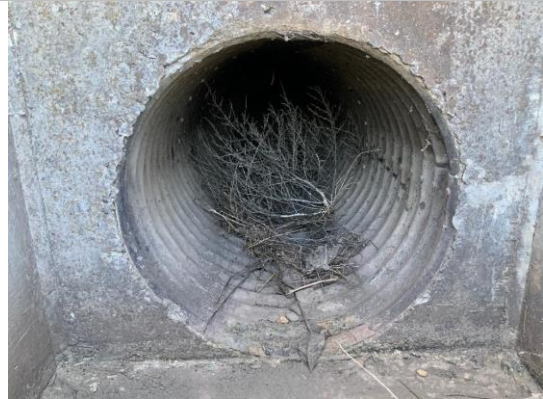
Photo 3 of 3 : UCIP_FA_2023_78966_92136.jpg

LS pipe, minor vegetation inside pipe.

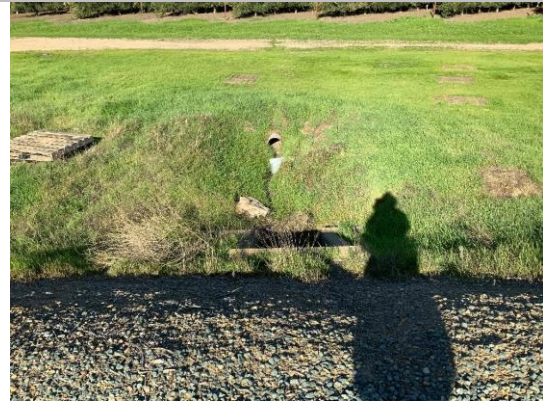
Photo 1 of 3 : UCIP_FA_2023_78981_92218.jpg

Comment Code						
Inspector Comment						
DS_ID:23590 FS_ID:78981 EP_NO: N/A Repair Type: Non-Urgent EVAL Issue: Crossing Status: Found UCIP Comments: 02/25/2021 The record has been upgraded from No Action Needed to Non-Urgent. DWR DMP has not found internal issues, LOF between 1 and 2. Recommend inspection in 5 years. No permit was found authorizing this encroachment. CVFPB will need to review crossing to determine owner. The UCIP inspection was completed with LMA representative, M. McCoy. (H. Dunn – GEI) FIELD_STRUCT_DESC: 24-inch corrugated metal storm drainage pipe (CMP) through the levee, 7.5 feet below the crown. Flap gate on the waterside (WS) end. Concrete U-shaped headwalls on both ends. Cobble grouted outlet across the berm. Cobble grouted apron on the landside (LS) end. [Additional Reference(s): DWR Levee Log, 1987, (HLM 11.78). USACE San Joaquin O&M Manual 612.2, 1967, (HLM 11.78), 24-inch pipe listed]. FS Date: 2/25/2021

LS view: LS headwall at toe from crown.

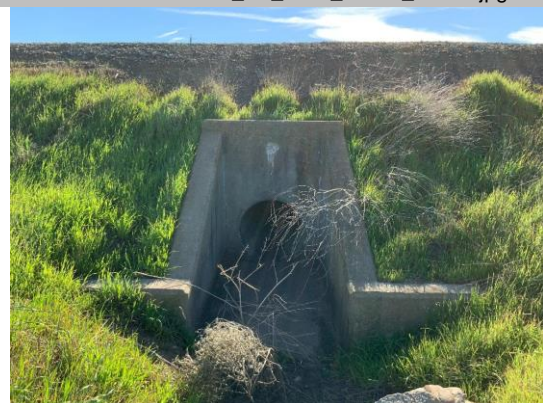
Photo 2 of 3 : UCIP_FA_2023_78981_92219.jpg

LS view: LS headwall at toe.

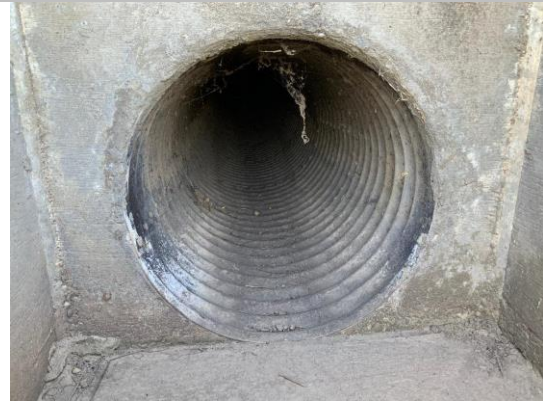
Photo 3 of 3 : UCIP_FA_2023_78981_92220.jpg

LS view: LS pipe.

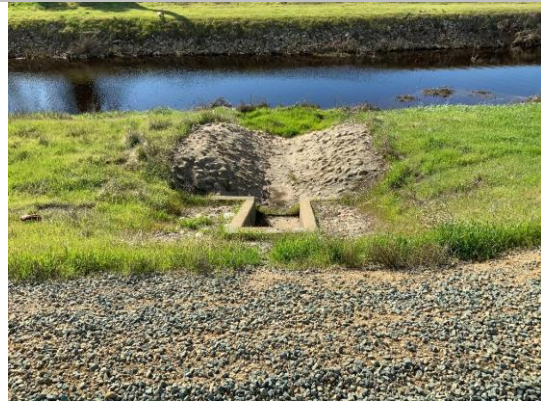
Photo 1 of 3 : UCIP_FA_2023_78968_92239.jpg

Comment Code					
Inspector Comment					
DS_ID:23593 FS_ID:78968 EP_NO: N/A Repair Type: Non-Urgent EVAL Issue: Crossing Status: Found UCIP Comments: 02/25/2021 Pipe status is still Non-Urgent. DWR DMP has not found internal issues, LOF between 1 and 2. Recommend inspection in 5 years. No permit was found authorizing this encroachment. CVFPB will need to review crossing to determine owner. The UCIP inspection was completed with LMA representative, M. McCoy. (H. Dunn – GEI) 05/14/2014 Some rocky debris buildup inside pipe on LS toe. (W. Wylie - DWR UCIP) FIELD_STRUCT_DESC: 24-inch corrugated metal storm drainage pipe (CMP) through the levee, 8.5 feet below the crown. Flap gate on the waterside (WS) end. Concrete U-shaped headwalls on both ends. Cobble grouted outlet across the berm. Cobble grouted apron on the landside (LS) end. [Additional Reference(s): DWR Levee Log, 1987, (HLM 12.30). USACE San Joaquin O&M Manual 612.2, 1967, (HLM 12.30), 24-inch pipe listed]. FS Date: 2/25/2021

WS headwall at toe from crown.

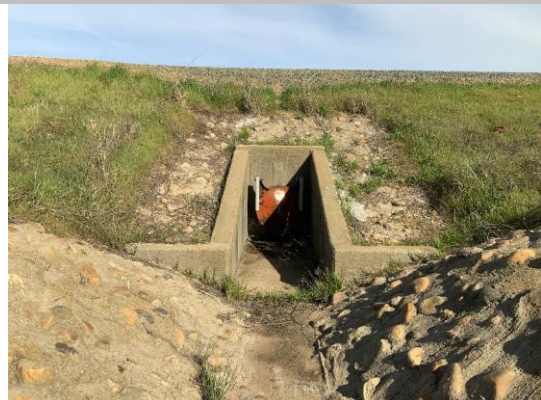
Photo 2 of 3 : UCIP_FA_2023_78968_92240.jpg

WS headwall and flapgate at toe.

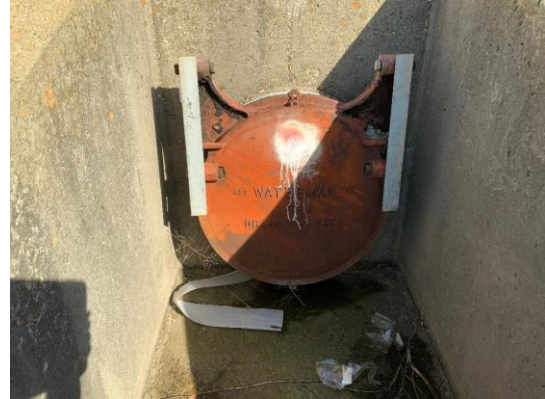
Photo 3 of 3 : UCIP_FA_2023_78968_92241.jpg

WS flapgate.

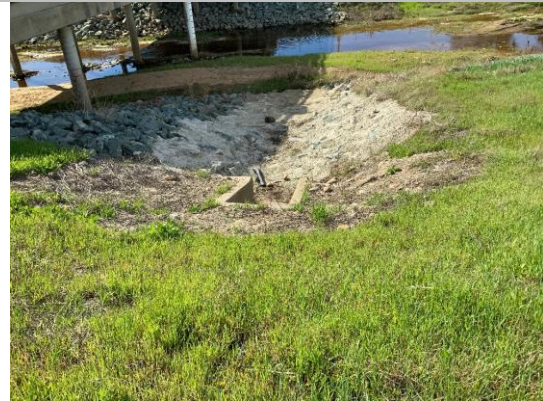
Photo 1 of 3 : UCIP_FA_2023_78918_92247.jpg

Comment Code					
Inspector Comment					
DS_ID:23594 FS_ID:78918 EP_NO: N/A Repair Type: Urgent EVAL Issue: 1, Pipe Integrity Crossing Status: Found UCIP Comments: 12/14/2022 Record updated from Non-Urgent to Urgent. DMP internal video inspection has found pipe integrity issues. LOF of crossing is between 5 and 6. Crossing will be monitored until funding becomes available to address the issues. (O.Yakimov - DWR UCIP) 02/25/2021 The record has been upgraded from No Action Needed to Non-Urgent. In August 2018, under the DWR DMP efforts the internal inspection found integrity issues, LOF between 5 and 6. According to Mr. Eric Ambriz, with San Joaquin County, Caltrans completed the slip Snap-Tite lining effort in October 2018. There is currently no post install inspection of the Snap-Tite lining. Unable to locate permit for sleeving PVC pipe. No permit was found authorizing original 24-inch CMP. CVFPB will need to review crossing to determine owner. The UCIP inspection was completed with LMA representative, M. Mccoy. (H. Dunn – GEI) 10/10/2018 20-inch Snap-Tite lining pipes were sleeved through the damaged 24-inch CMP culvert. Annular space was pressure grouted. (A. McDonald - DWR UCIP) FIELD_STRUCT_DESC: 24-inch corrugated metal storm drainage pipe (CMP) sleeved with a 20-inch Snap-Tite culvert lining pipe through the levee, 7.5 feet below the crown. Annular space pressure grouted. Flap gate on the waterside (WS) end. Concrete U-shaped headwalls on each end. Cobble grouted outlet across the berm. Cobble grouted apron on the landside (LS) end. [Additional Reference(s): DWR Levee Log, 1987, (HLM 12.40). USACE San Joaquin O&M Manual 612.2, 1967, (HLM 12.40), 24-inch pipe listed]. FS Date: 2/25/2021 3:15:52 PM

WS view: WS headwall at toe from crown.

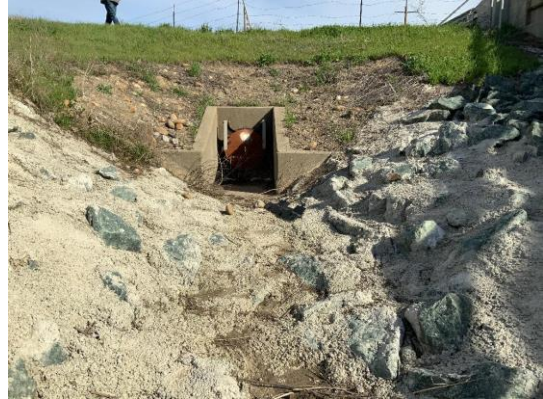
Photo 2 of 3 : UCIP_FA_2023_78918_92248.jpg

WS view: WS headwall and flapgate at toe.

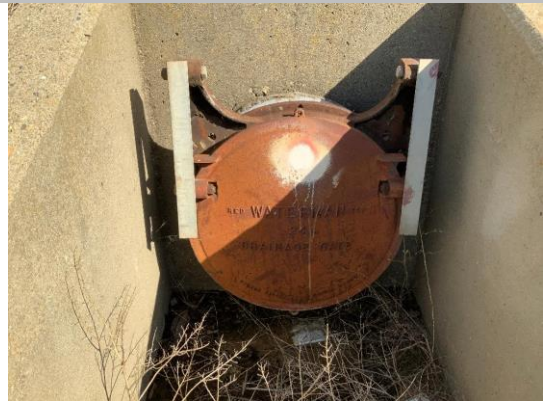
Photo 3 of 3 : UCIP_FA_2023_78918_92249.jpg

WS view: WS flapgate.

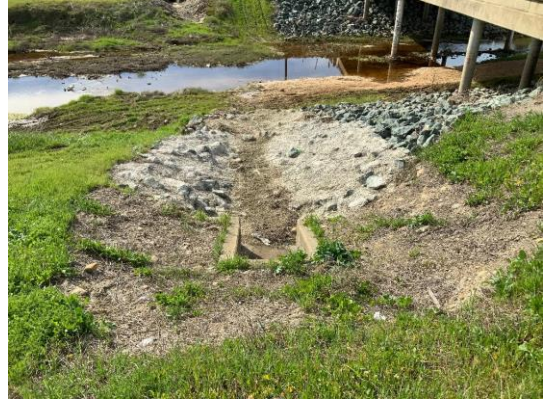
Photo 1 of 3 : UCIP_FA_2023_78919_92256.jpg

Comment Code						
Inspector Comment						
DS_ID:23505 FS_ID:78919 EP_NO: N/A Repair Type: Non-Urgent EVAL Issue: Crossing Status: Found UCIP Comments: 02/25/2021 The record has been upgraded from No Action Needed to Non-Urgent. Edges of LS pipe are warped. DWR DMP has not found internal issues, LOF between 1 and 2. Recommend inspection in 5 years. No permit was found authorizing this encroachment. CVFPB will need to review crossing to determine owner. The UCIP inspection was completed with LMA representative, M. Mccoy. (H. Dunn – GEI) FIELD_STRUCT_DESC: 24-inch corrugated metal storm drainage pipe (CMP) through the levee, 7.5 feet below the crown. Flap gate on the waterside (WS) end. Concrete U-shaped headwalls on both ends. Cobble grouted outlet across the berm. Cobble grouted apron on the landside (LS) end. [Additional Reference(s): DWR Levee Log, 1987, (HLM 12.42). USACE San Joaquin O&M Manual 612.2, 1967, (HLM 12.42), 24-inch pipe listed]. FS Date: 2/25/2021

WS view: WS headwall at toe from crown.

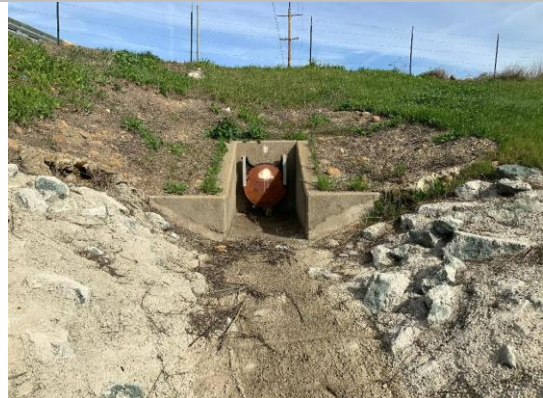
Photo 2 of 3 : UCIP_FA_2023_78919_92257.jpg

WS view: WS headwall and flapgate at toe.

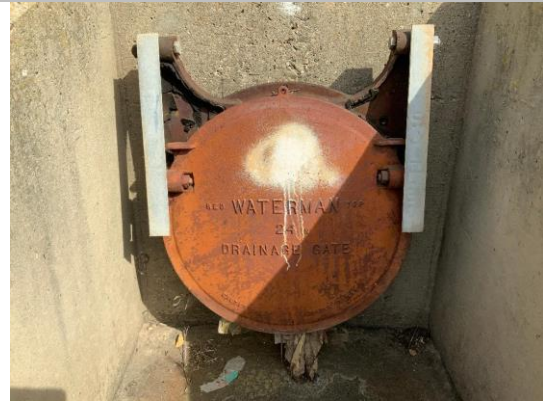
Photo 3 of 3 : UCIP_FA_2023_78919_92258.jpg

WS view: WS flapgate.

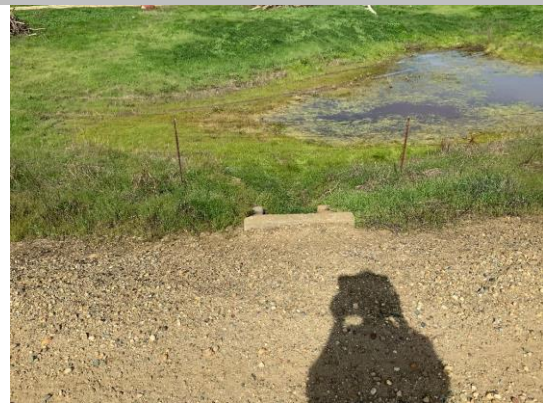
Photo 1 of 3 : UCIP_FA_2023_78970_92274.jpg

DS_ID:23507
 FS_ID:78970
 EP_NO: N/A
 Repair Type: Non-Urgent
 EVAL Issue:
 Crossing Status: Found
 UCIP Comments: 02/25/2021 The record has been upgraded from No Action Needed to Non-Urgent. DWR DMP has not found internal issues, LOF between 1 and 2. Recommend inspection in 5 years. No permit was found authorizing this encroachment. CVFPB will need to review crossing to determine owner. The UCIP inspection was completed with LMA representative, M. McCoy. (H. Dunn – GEI)
 FIELD_STRUCT_DESC: 24-inch corrugated metal storm drainage pipe (CMP) through the levee, 7.5 feet below the crown. Flap gate on the waterside (WS) end. Concrete U-shaped headwalls on both ends. Cobble grouted outlet across the berm. Cobble grouted apron on the landside (LS) end. [Additional Reference(s): DWR Levee Log, 1987, (HLM 12.64). USACE San Joaquin O&M Manual 612.2, 1967, (HLM 12.64), and 612 (addendum), February 1999, (HLM 12.61), (Station 666+02), 24-inch pipe listed].

LS view: LS headwall at toe from crown.

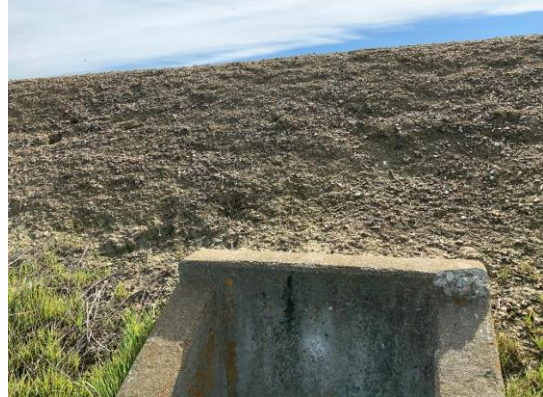
Photo 2 of 3 : UCIP_FA_2023_78970_92276.jpg

LS view: LS headwall at toe.

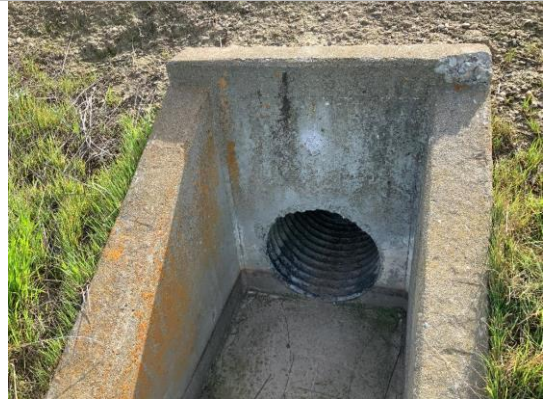
Photo 3 of 3 : UCIP_FA_2023_78970_92275.jpg

LS view: LS headwall at toe.

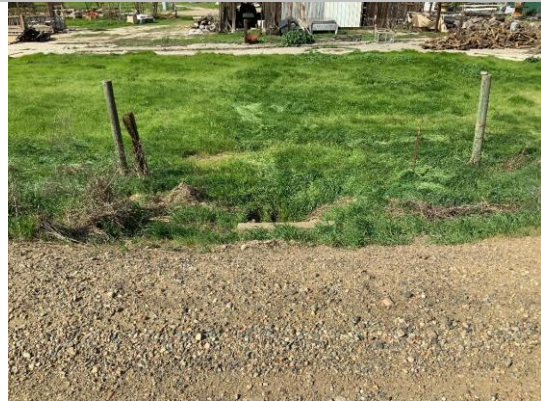
Photo 1 of 3 : UCIP_FA_2023_78971_92282.jpg

Comment Code					
Inspector Comment					
DS_ID:23508 FS_ID:78971 EP_NO: N/A Repair Type: Non-Urgent EVAL Issue: 5, Pipe Damage Crossing Status: Found UCIP Comments: 02/25/2021 The record has been upgraded from No Action Needed to Non-Urgent. DWR DMP has found integrity issues, LOF between 4 and 5. Crossing will be monitored until funding becomes available for rehabilitation. Recommend maintenance to clear up sediment buildup through LS pipe. No permit was found authorizing this encroachment. CVFPB will need to review crossing to determine owner. The UCIP inspection was completed with LMA representative, M. Mccoy. (H. Dunn – GEI) FIELD_STRUCT_DESC: 24-inch corrugated metal storm drainage pipe (CMP) through the levee, 7.5 feet below the crown. Flap gate on the waterside (WS) end. Concrete U-shaped headwalls on both ends. Cobble grouted outlet across the berm. Cobble grouted apron on the landside (LS) end. [Additional Reference(s): DWR Levee Log, 1987, (HLM 12.72). USACE San Joaquin O&M Manual 612.2, 1967, (HLM 12.72), and 612 (addendum), February 1999, (HLM 12.71), (Station 671+24), 24-inch pipe listed]. FS Date: 2/25/2021

LS view: LS headwall at toe from crown.

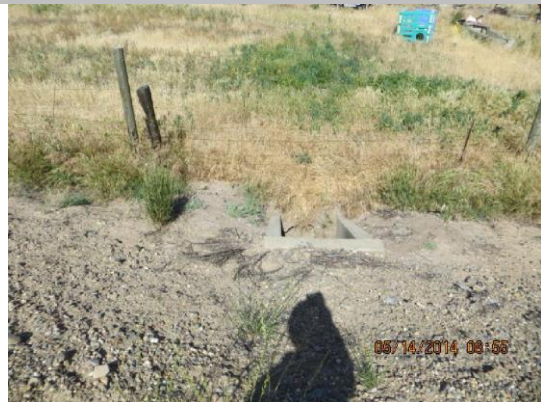
Photo 2 of 3 : UCIP_FA_2023_78971_68555.jpg

Pipe and headwall at LS toe.

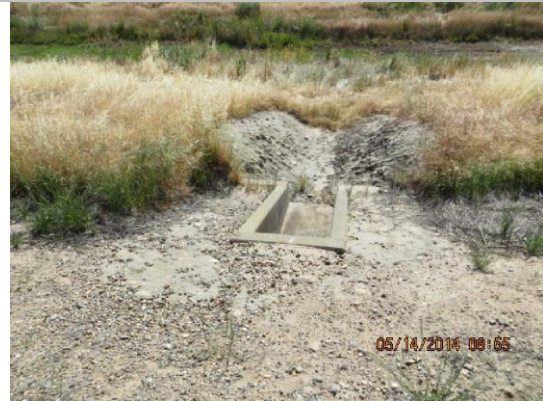
Photo 3 of 3 : UCIP_FA_2023_78971_68554.jpg

Pipe, flap gate, headwall, and cobble grouted outlet on the WS toe.

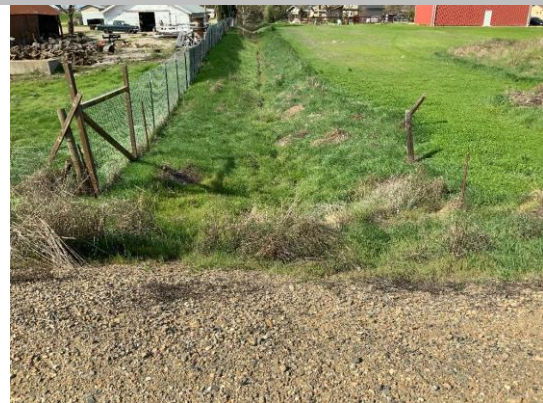
Photo 1 of 3 : UCIP_FA_2023_78922_92291.jpg

DS_ID:23509
 FS_ID:78922
 EP_NO: N/A
 Repair Type: Non-Urgent
 EVAL Issue:
 Crossing Status: Found
 UCIP Comments: 02/25/2021 The record has been upgraded from No Action Needed to Non-Urgent. DWR DMP internal inspection has not found pipe integrity issues. LOF of crossing is less or equal to 4.0. Recommend next video inspection in 5 years. No permit was found authorizing this encroachment. CVFPB will need to review crossing to determine owner. The UCIP inspection was completed with LMA representative, M. McCoy. (H. Dunn – GEI)
 FIELD_STRUCT_DESC: 24-inch corrugated metal storm drainage pipe (CMP) through the levee, 7.5 feet below the crown. Flap gate on the waterside (WS) end. Concrete U-shaped headwalls on both ends. Cobble grouted outlet across the berm. Cobble grouted apron on the landside (LS) end. [Additional Reference(s): DWR Levee Log, 1987, (HLM 12.74). USACE San Joaquin O&M Manual 612.2, 1967, (HLM 12.74), and 612 (addendum), February 1999, (HLM 12.73), (Station 672+05), 24-inch pipe listed].

LS view: LS headwall at toe from crown.

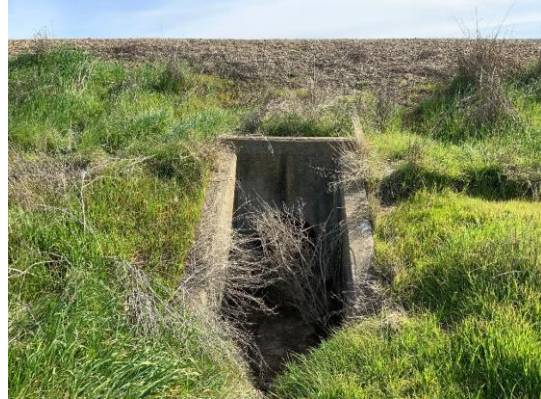
Photo 2 of 3 : UCIP_FA_2023_78922_95682.jpg

LS view: Headwall at toe.

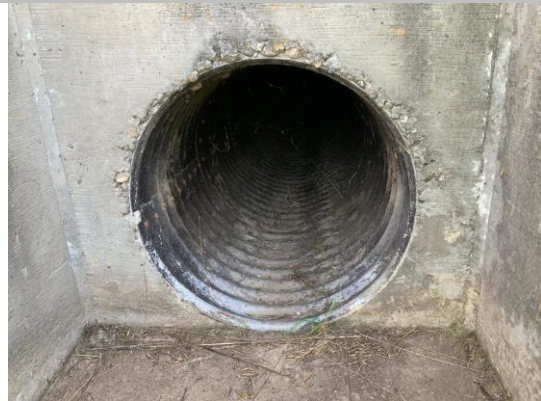
Photo 3 of 3 : UCIP_FA_2023_78922_95683.jpg

LS view: Pipe inlet, 1 of 2 photos.

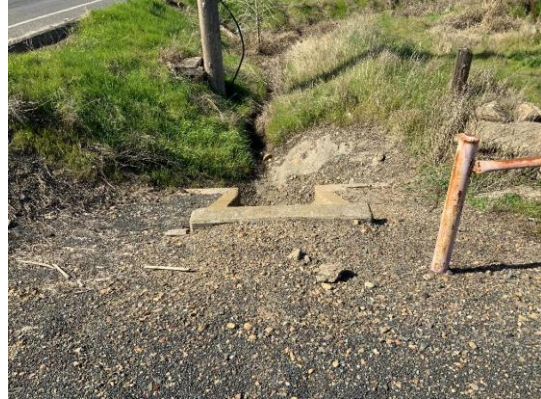
Photo 1 of 3 : UCIP_FA_2023_78923_92340.jpg

Comment Code					
Inspector Comment					
DS_ID:23512 FS_ID:78923 EP_NO: N/A Repair Type: Non-Urgent EVAL Issue: Crossing Status: Found UCIP Comments: 02/25/2021 The record has been upgraded from No Action Needed to Non-Urgent. DWR DMP has not found internal issues, LOF between 1 and 2. Recommend inspection in 5 years. No permit was found authorizing this encroachment. CVFPB will need to review crossing to determine owner. The UCIP inspection was completed with LMA representative, M. Mccoy. (H. Dunn – GEI) FIELD_STRUCT_DESC: 24-inch corrugated metal storm drainage pipe (CMP) through the levee, 7.0 feet below the crown. Flap gate on the waterside (WS) end. Concrete U-shaped headwalls on both ends. Cobble grouted outlet on the WS. Cobble grouted intake on the landside (LS). [Additional Reference(s): DWR Levee Log, 1987, (HLM 13.29). USACE San Joaquin O&M Manual 612.2, 1967, (HLM 13.29), 24-inch pipe listed]. FS Date: 2/25/2021

LS view: LS headwall at toe from crown.

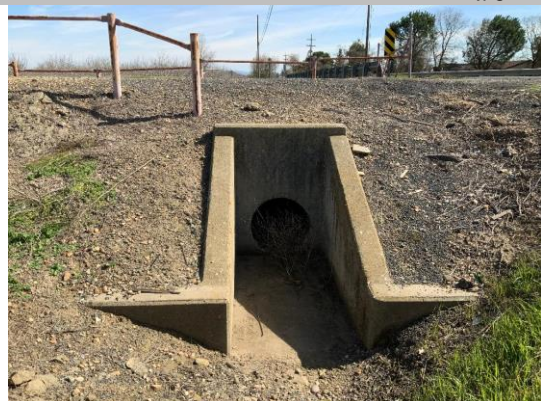
Photo 2 of 3 : UCIP_FA_2023_78923_92341.jpg

LS view: LS headwall at toe.

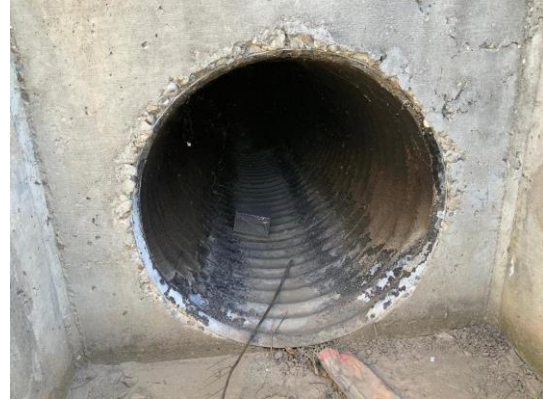
Photo 3 of 3 : UCIP_FA_2023_78923_92342.jpg

LS view: LS pipe.

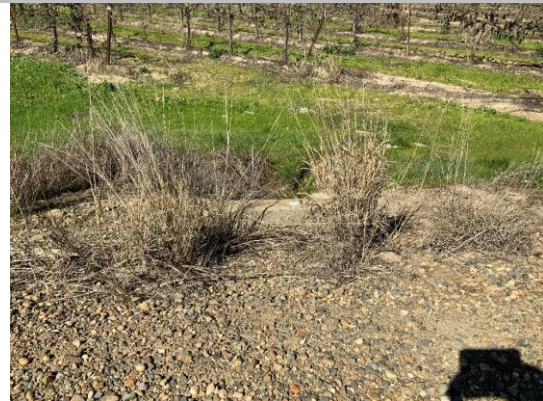
Photo 1 of 3 : UCIP_FA_2023_78972_92446.jpg

DS_ID:23597
 FS_ID:78972
 EP_NO: N/A
 Repair Type: Non-Urgent
 EVAL Issue:
 Crossing Status: Found
 UCIP Comments: 02/25/2021 The record has been upgraded from No Action Needed to Non-Urgent. DWR DMP has not found internal issues, LOF between 1 and 2. Recommend inspection in 5 years. No permit was found authorizing this encroachment. CVFPB will need to review crossing to determine owner. The UCIP inspection was completed with LMA representative, M. McCoy. (H. Dunn – GEI)
 FIELD_STRUCT_DESC: 24-inch corrugated metal storm drainage pipe (CMP) through the levee, 5.5 feet below the crown. Flap gate on the waterside (WS) end. Concrete U-shaped headwalls on both ends. Cobble grouted outlet on the WS. Cobble grouted intake on the landside (LS). [Additional Reference(s): DWR Levee Log, 1987, (HLM 13.64). USACE San Joaquin O&M Manual 612.2, 1967, (HLM 13.64), 24-inch pipe listed].
 FS Date: 2/25/2021

LS view: LS headwall at toe from crown.

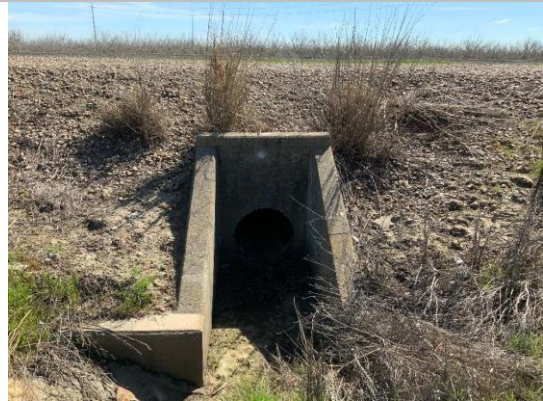
Photo 2 of 3 : UCIP_FA_2023_78972_92447.jpg

LS view: LS headwall at toe.

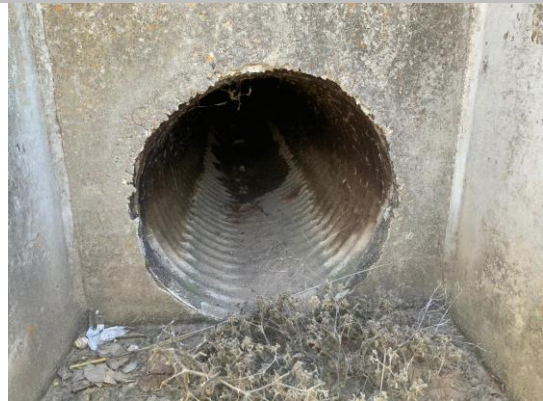
Photo 3 of 3 : UCIP_FA_2023_78972_92448.jpg

LS view: LS pipe.

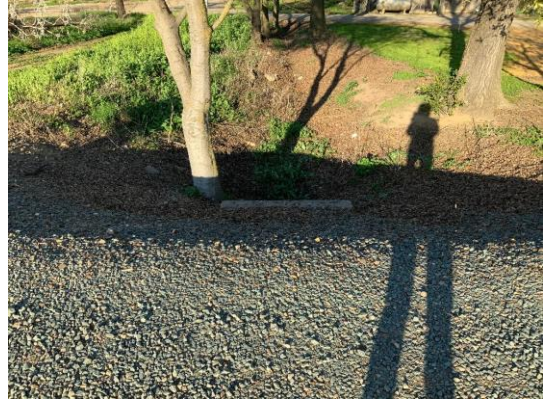
Photo 1 of 3 : UCIP_FA_2023_78973_92704.jpg

Comment Code						
Inspector Comment						
DS_ID:23598 FS_ID:78973 EP_NO: N/A Repair Type: Non-Urgent EVAL Issue: Crossing Status: Found UCIP Comments: 02/26/2021 The record has been upgraded from No Action Needed to Non-Urgent. DWR DMP has not found internal issues, LOF between 1 and 2. Recommend inspection in 5 years. No permit was found authorizing this encroachment. CVFPB will need to review crossing to determine owner. The UCIP inspection was completed with LMA representative, J. Caruso. (H. Dunn – GEI) FIELD_STRUCT_DESC: 24-inch corrugated metal storm drainage pipe (CMP) through the levee, 7.5 feet below the crown. Flap gate on the waterside (WS) end. Concrete U-shaped headwalls on both ends. Cobble grouted outlet on the WS. Cobble grouted intake on the landside (LS) slope. [Additional Reference(s): DWR Levee Log, 1987, (HLM 14.04). USACE San Joaquin O&M Manual 612.2, 1967, (HLM 14.04), 24-inch pipe listed]. FS Date: 2/26/2021

LS headwall at toe from crown.

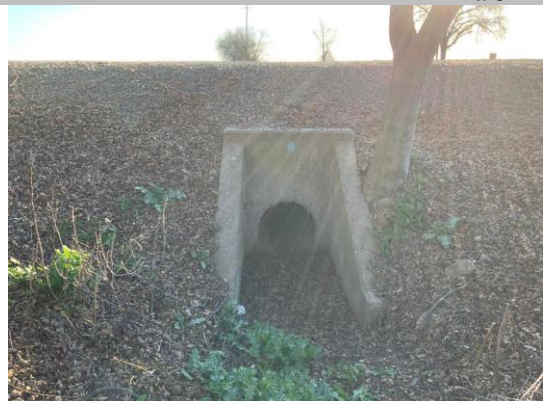
Photo 2 of 3 : UCIP_FA_2023_78973_92705.jpg

LS headwall at toe.

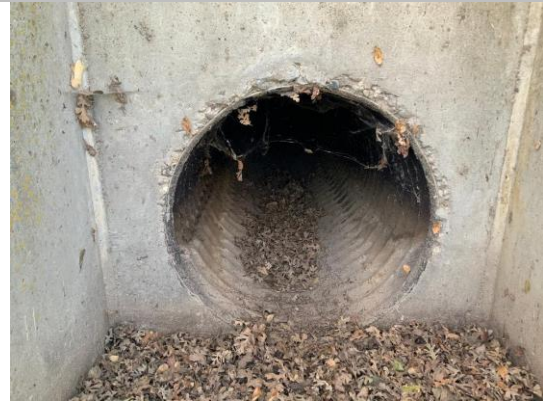
Photo 3 of 3 : UCIP_FA_2023_78973_92706.jpg

LS pipe.

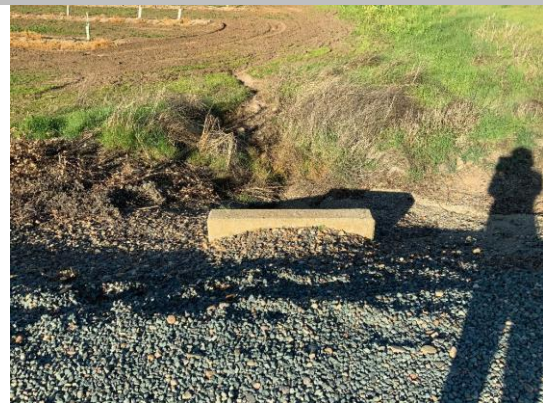
Photo 1 of 3 : UCIP_FA_2023_78974_92726.jpg

DS_ID:23600
 FS_ID:78974
 EP_NO: N/A
 Repair Type: Non-Urgent
 EVAL Issue:
 Crossing Status: Found
 UCIP Comments: 02/26/2021 The record has been upgraded from No Action Needed to Non-Urgent. DWR DMP has not found internal issues, LOF between 1 and 2. Recommend inspection in 5 years. No permit was found authorizing this encroachment. CVFPB will need to review crossing to determine owner. The UCIP inspection was completed with LMA representative, J. Caruso. (H. Dunn – GEI)
 FIELD_STRUCT_DESC: 24-inch corrugated metal storm drainage pipe (CMP) through the levee, 6.0 feet below the crown. Flap gate on the waterside (WS) end. Concrete U-shaped headwalls on both ends. Cobble grouted outlet on the WS. [Additional Reference(s): DWR Levee Log, 1987, (HLM 14.37). USACE San Joaquin O&M Manual 612.2, 1967, (HLM 14.37), 24-inch pipe listed].
 FS Date: 2/26/2021

LS view: LS headwall at toe from crown.

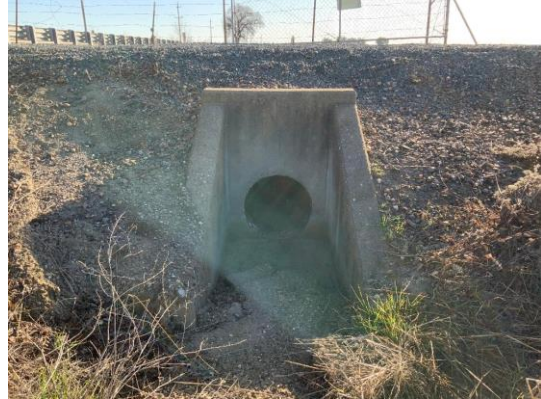
Photo 2 of 3 : UCIP_FA_2023_78974_92727.jpg

LS view: LS headwall at toe.

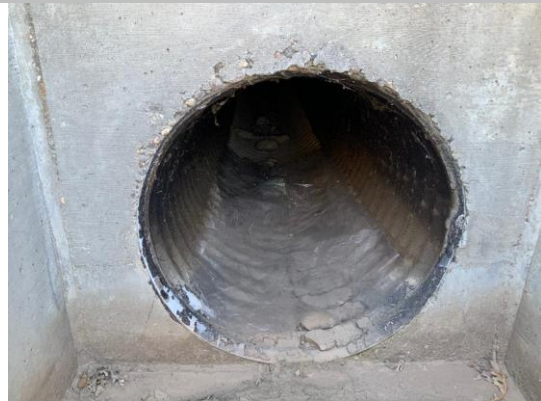
Photo 3 of 3 : UCIP_FA_2023_78974_92728.jpg

LS view: LS pipe.

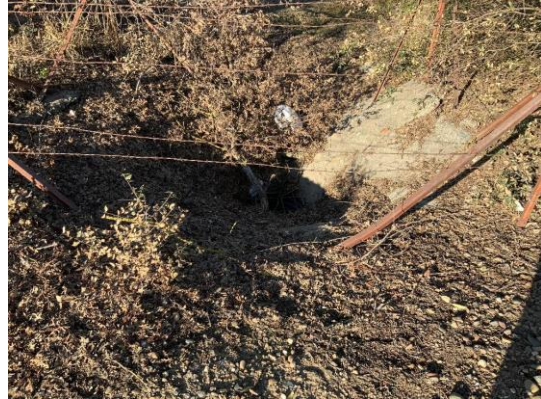
Photo 1 of 3 : UCIP_FA_2023_78927_92737.jpg

Comment Code					
Inspector Comment					
DS_ID:23601 FS_ID:78927 EP_NO: N/A Repair Type: Non-Urgent EVAL Issue: 5, Pipe Damage Crossing Status: Found UCIP Comments: 02/26/2021 Record record has been updated from No Action Needed to Non-Urgent. DWR DMP has found integrity issues, LOF between 4 and 5. Crossing will be monitored until funding becomes available for rehabilitation. No permit was found authorizing this encroachment. CVFPB will need to review crossing to determine owner. The UCIP inspection was completed with LMA representative, J. Caruso. (H. Dunn GEI) FIELD_STRUCT_DESC: 24-inch corrugated metal storm drainage pipe (CMP) through the levee, 8.0 feet below the crown. Flap gate on the waterside (WS) end. Concrete U-shaped headwall on the WS end. Cobble grouted outlet on the WS. 24-inch CMP drop inlet and cobble grouted intake on the landside (LS), no headwall. (Drainage ditch and 12-inch culverts adjacent to levee authorized under Permit No. 12659, 1979 - Richard Stasand). [Additional Reference(s): DWR Levee Log, 1987, (HLM 14.39). USACE San Joaquin O&M Manual 612.2, 1967, (HLM 14.39), 24-inch pipe listed]. FS Date: 2/26/2021

LS view: LS toe inlet, surrounded by barbed wire.

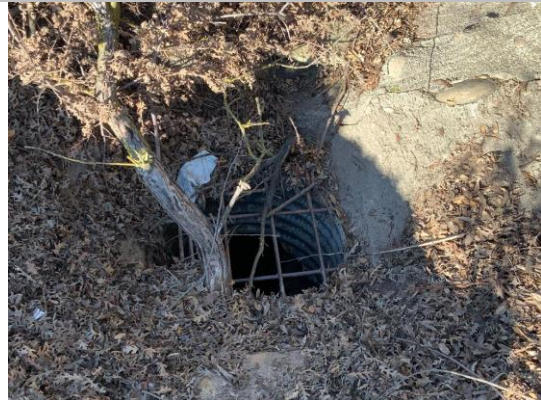
Photo 2 of 3 : UCIP_FA_2023_78927_92738.jpg

LS view: LS toe pipe and inlet.

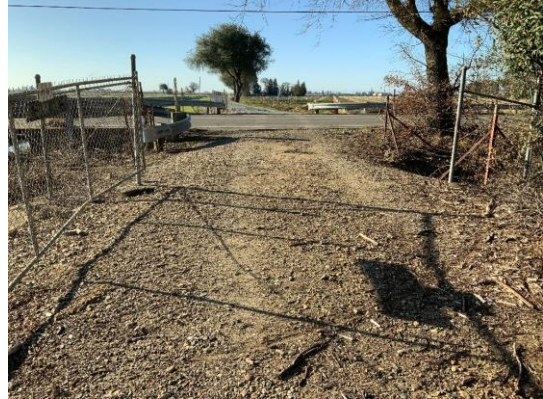
Photo 3 of 3 : UCIP_FA_2023_78927_92733.jpg

Levee crown looking downstream.

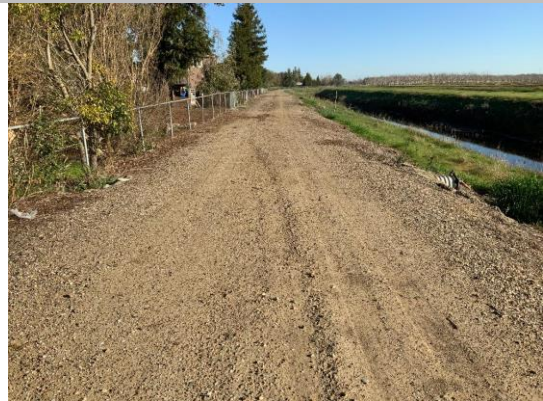
Photo 1 of 3 : UCIP_FA_2023_79423_92758.jpg

DS_ID:23602
 FS_ID:79423
 EP_NO: N/A
 Repair Type: Non-Urgent
 EVAL Issue: 5, Pipe Damage
 Crossing Status: Found
 UCIP Comments: 03/31/2023 Record updated from Urgent to Non-Urgent. LoF is equal to 5.1 due to pipe deformation, integrity issues are not found. Crossing will be monitored until funding becomes available for rehabilitation. (O.Yakimov - DWR UCIP).
 02/26/2021 Record has been updated from No Action Needed to Urgent. DWR DMP has found integrity issues, LOF between 5 and 6. Recommend monitoring crossing until funding becomes available to address. WS outlet is slightly overgrown with vegetation. No permit was found authorizing this encroachment. CVFPB will need to review crossing to determine owner. LS flap gate is broken and needs repair. The UCIP inspection was completed with LMA representative, J. Caruso. (H. Dunn ? GEI)
 FIELD_STRUCT_DESC: 12-inch corrugated metal drainage pipe (CMP) through the levee, 1.0 foot below the crown. Cobble grouted inlet at fish pond on the landside (LS) toe. [Additional Reference(s): DWR Levee Log, 1987, (HLM 14.42), 7-inch pipe listed. USACE San Joaquin O&M Manual 612.2, 1967, (HLM 14.42), 7-inch pipe listed].

Levee crown looking upstream.

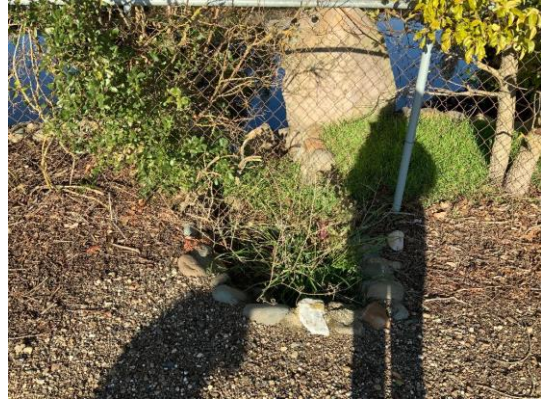
Photo 2 of 3 : UCIP_FA_2023_79423_92759.jpg

LS view: LS inlet at toe from crown.

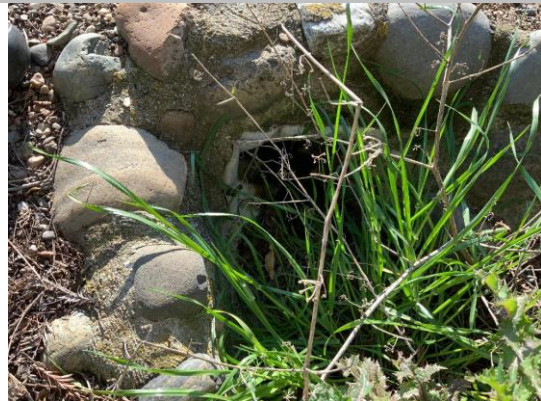
Photo 3 of 3 : UCIP_FA_2023_79423_92760.jpg

LS view: LS pipe at toe.

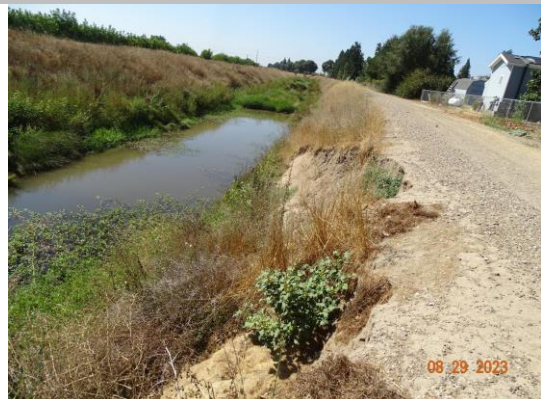
Photo 1 of 2 : SJR2023_NA0017U07RM21.29_1.JPG

8/29/2023: The site was discovered by the LMA and visited during the annual field survey. There is a 6 foot vertical scarp approximately 100 feet long along the patrol road hinge.

8/29/2023: View of erosion.

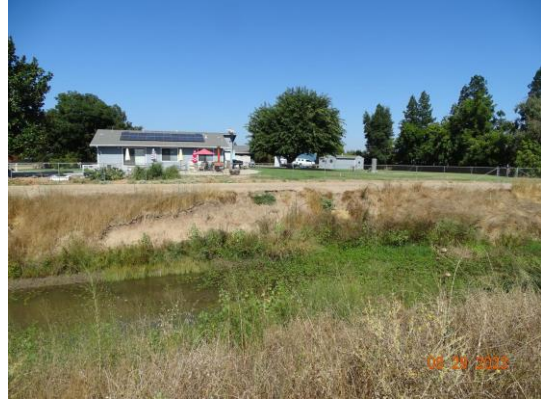
Photo 2 of 2 : SJR2023_NA0017U07_RM21.29_2.JPG

8/29/2023: View of erosion from opposite bank.

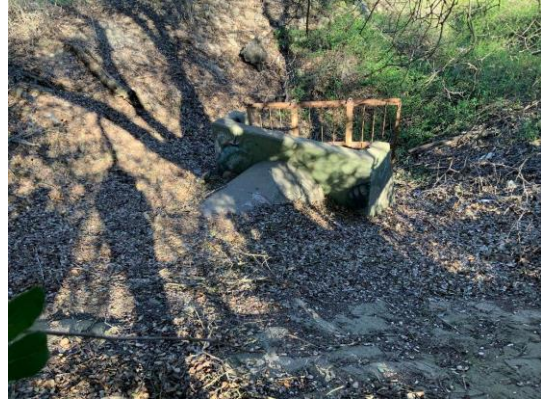
Photo 1 of 3 : UCIP_FA_2023_78928_92790.jpg

Comment Code						
Inspector Comment						
DS_ID:23604 FS_ID:78928 EP_NO: N/A Repair Type: No Action Needed EVAL Issue: Crossing Status: Found UCIP Comments: 02/26/2021 Record updated from Non-Urgent to No Action Needed. Unit 7 ? Bear Creek (CLM 13.95 to 14.90) is considered a patrol road/high ground area with no defined levee prism, any issue found between CLM 13.95 to 14.90 of Unit 7 will be considered a maintenance issue, or an unauthorized encroachment, or an abandoned encroachment. DMP internal video inspection has found none or minor pipe defects. Current condition of pipe crossing does not impede access to patrol road/high ground area. No permit was found authorizing this encroachment. CVFPB will need to review crossing to determine owner.. The UCIP inspection was completed with LMA representative, J. Caruso. (H. Dunn ? GEI) 05/12/2014 No flapgate. (W. Wylie - DWR UCIP) FIELD_STRUCT_DESC: *High Ground* 48-inch reinforced concrete drainage pipe (RCP) through the levee, 9.0 feet below the crown. Concrete headwall with trash rack on the landside (LS). Cobble grouted intake on the LS. Cobble grouted outlet on the waterside (WS). Open on both ends. [Additional Reference(s): DWR Levee Log, 1987, (HLM 15.00). USACE San Joaquin O&M Manual 612.2, 1967, (HLM 15.00), 48-inch pipe listed]. FS Date: 2/26/2021

LS view: LS headwall off of the toe.

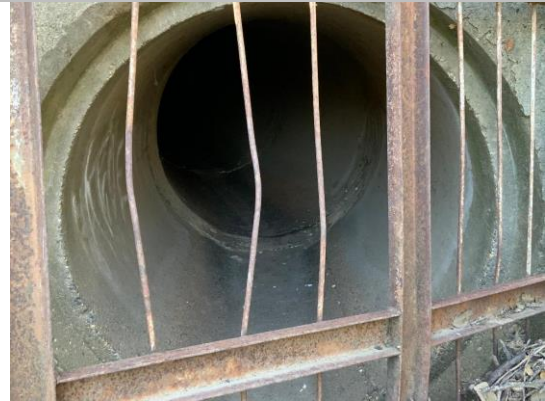
Photo 3 of 3 : UCIP_FA_2023_78928_92792.jpg

LS view: LS pipe.

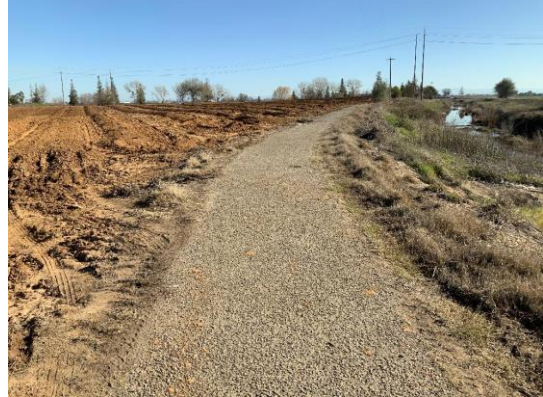
Photo 2 of 3 : UCIP_FA_2023_78976_92805.jpg

DS_ID:23605
 FS_ID:78976
 EP_NO: N/A
 Repair Type: Non-Urgent
 EVAL Issue: 11, Maintenance Compliance Issue
 Crossing Status: Found
 UCIP Comments: 02/26/2021 Record remains Non-Urgent. Unit 7 – Bear Creek (CLM 13.95 to 14.90) is considered a patrol road/high ground area with no defined levee prism, any issue found between CLM 13.95 to 14.90 of Unit 7 will be considered a maintenance issue, or an unauthorized encroachment, or an abandoned encroachment. DWR DMP has found integrity issues, LOF between 5 and 6. Crossing will be monitored until funding becomes available to address. Current condition of pipe crossing does not impede access to patrol road/high ground area. No permit was found authorizing this encroachment. CVFPB will need to review crossing to determine owner. The UCIP inspection was completed with LMA representative, J. Caruso. (H. Dunn – GEI)

Levee crown looking upstream.

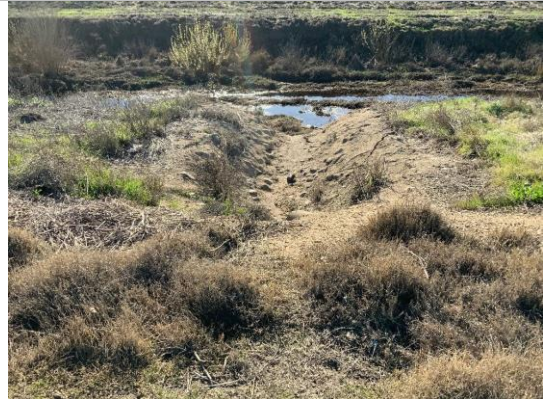
Photo 3 of 3 : UCIP_FA_2023_78976_92806.jpg

WS view: WS pipe at toe from crown.

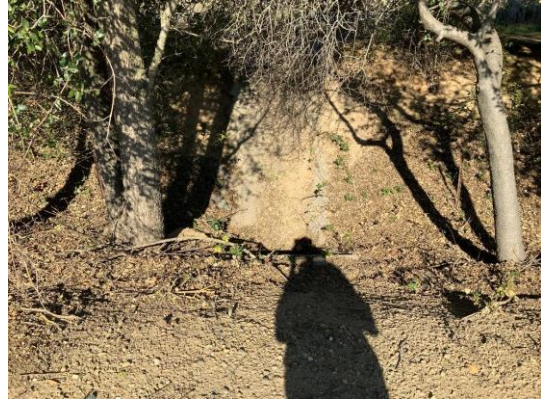
Photo 1 of 3 : UCIP_FA_2023_78977_92824.jpg

Comment Code						
Inspector Comment						
DS_ID:23607 FS_ID:78977 EP_NO: N/A Repair Type: Non-Urgent EVAL Issue: Crossing Status: Found UCIP Comments: 02/26/2021 The record has been upgraded from No Action Needed to Non-Urgent. DWR DMP has not found internal issues, LOF between 1 and 2. Recommend inspection in 5 years. No permit was found authorizing this encroachment. CVFPB will need to review crossing to determine owner. The UCIP inspection was completed with LMA representative, J. Caruso. (H. Dunn – GEI) FIELD_STRUCT_DESC: 24-inch corrugated metal storm drainage pipe (CMP) through the levee, 5.5 feet below the crown. Flap gate on the waterside (WS) end. Concrete U-shaped headwalls on both ends. Cobble grouted outlet on the WS. Cobble grouted intake on the landside (LS). [Additional Reference(s): DWR Levee Log, 1987, (HLM 15.51). USACE San Joaquin O&M Manual 612.2, 1967, (HLM 15.50), 24-inch pipe listed]. FS Date: 2/26/2021

LS view: LS headwall at toe from crown.

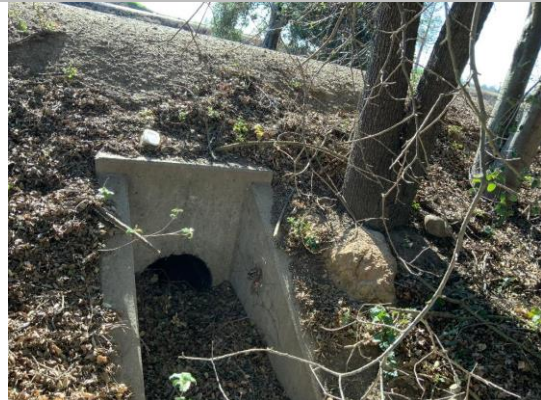
Photo 2 of 3 : UCIP_FA_2023_78977_92825.jpg

LS view: LS headwall at toe.

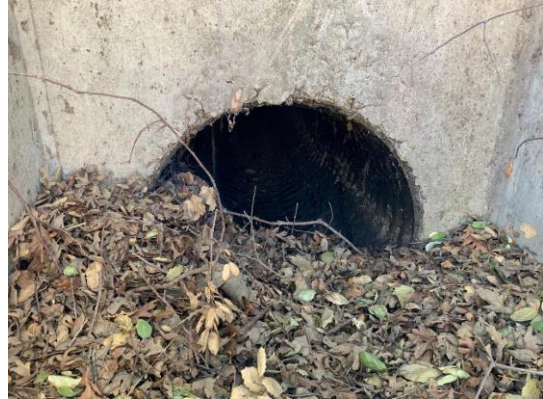
Photo 3 of 3 : UCIP_FA_2023_78977_92826.jpg

LS view: LS pipe, vegetation debris covering pipe.

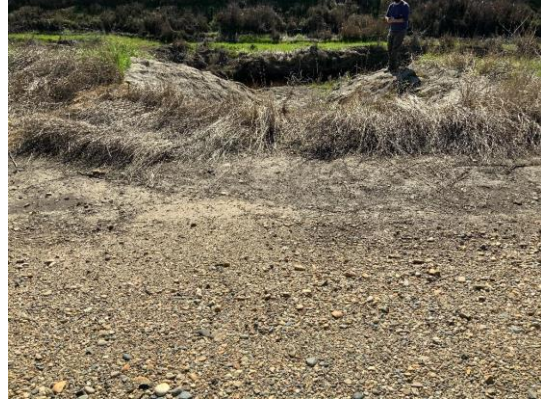
Photo 1 of 3 : UCIP_FA_2023_78978_92893.jpg

Comment Code						
Inspector Comment						
DS_ID:23609 FS_ID:78978 EP_NO: N/A Repair Type: Non-Urgent EVAL Issue: Crossing Status: Found UCIP Comments: 02/26/2021 The record has been upgraded from No Action Needed to Non-Urgent. DWR DMP has not found internal issues, LOF between 1 and 2. Recommend inspection in 5 years. No permit was found authorizing this encroachment. CVFPB will need to review crossing to determine owner. The UCIP inspection was completed with LMA representative, J. Caruso. (H. Dunn – GEI) 05/12/2014 Rodent hole on crown side of headwall on WS slope. (W. Wylie - DWR UCIP) FIELD_STRUCT_DESC: 24-inch corrugated metal storm drainage pipe (CMP) through the levee, 7.5 feet below the crown. Flap gate on the waterside (WS) end. Concrete U-shaped headwalls on both ends. Cobble grouted outlet on the WS. Cobble grouted intake on the landside (LS). [Additional Reference(s): DWR Levee Log, 1987, (HLM 15.68). USACE San Joaquin O&M Manual 612.2, 1967, (HLM 15.68), 24-inch pipe listed]. FS Date: 2/26/2021

WS view: WS headwall at toe from crown.

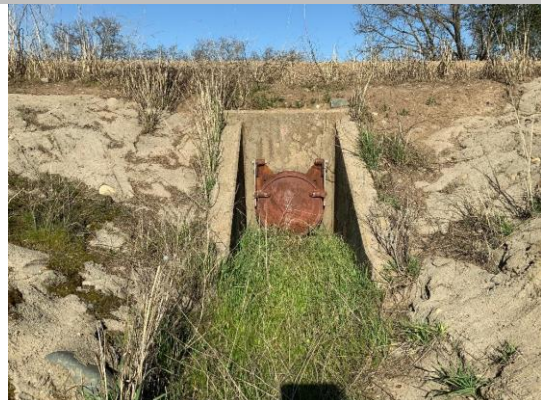
Photo 2 of 3 : UCIP_FA_2023_78978_92894.jpg

WS view: WS headwall and flapgate at toe.

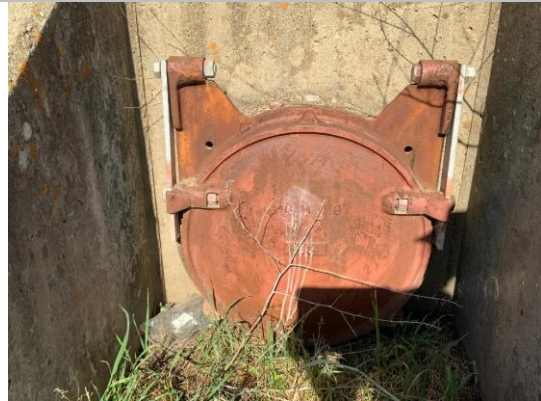
Photo 3 of 3 : UCIP_FA_2023_78978_92895.jpg

WS view: WS flapgate.

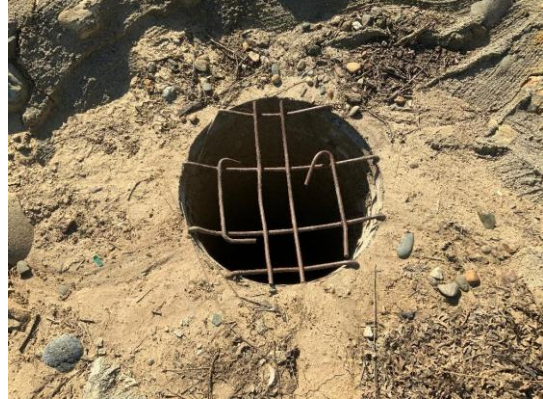
Photo 2 of 3 : UCIP_FA_2023_78389_92906.jpg

DS_ID:23610
 FS_ID:78389
 EP_NO: N/A
 Repair Type: Non-Urgent
 EVAL Issue: 4b, Safety Issue
 Crossing Status: Found
 UCIP Comments: 02/26/2021 Pipe status is still Non-Urgent. LS inlet only has wiring covering it, no cover or riser, safety concern. DWR DMP has not found internal issues, LOF between 1 and 2. Recommend inspection in 5 years. No permit was found authorizing this encroachment. CVFPB will need to review crossing to determine owner. The UCIP inspection was completed with LMA representative, J. Caruso. (H. Dunn – GEI) 05/12/2014 No inlet cover or grate at LS toe. (W. Wylie - DWR UCIP)
 FIELD_STRUCT_DESC: 24-inch corrugated metal storm drainage pipe (CMP) through the levee, 11.0 feet below the crown. Flap gate on the waterside (WS) end. Concrete U-shaped headwall on the WS end. 24-inch CMP riser unit/drop inlet on the landside (LS). [Additional Reference(s): DWR Levee Log, 1987, (HLM 15.80). USACE San Joaquin O&M Manual 612.2, 1967, (HLM 15.80), 24-inch pipe listed].

LS view: LS pipe inlet, no cover, safety concern.

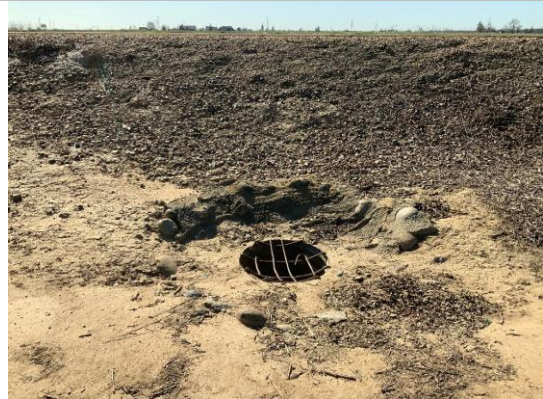
Photo 3 of 3 : UCIP_FA_2023_78389_92907.jpg

LS view: LS pipe inlet at toe, safety concern.

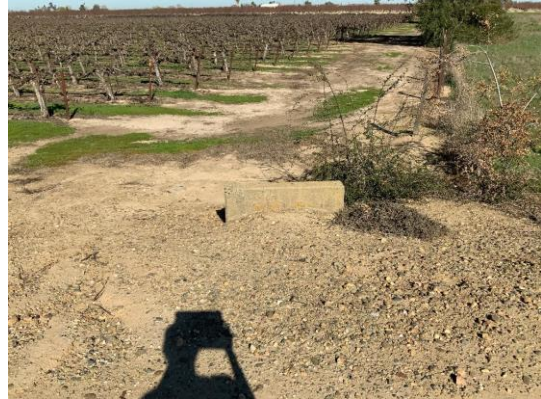
Photo 1 of 3 : UCIP_FA_2023_78979_92920.jpg

Comment Code						
Inspector Comment						
DS_ID:23611 FS_ID:78979 EP_NO: N/A Repair Type: Non-Urgent EVAL Issue: Crossing Status: Found UCIP Comments: 02/26/2021 The record has been upgraded from No Action Needed to Non-Urgent. Some peeling away of metal on inside edge of WS pipe. DWR DMP has not found internal issues, LOF between 1 and 2. Recommend inspection in 5 years. No permit was found authorizing this encroachment. CVFPB will need to review crossing to determine owner. The UCIP inspection was completed with LMA representative, J. Caruso. (H. Dunn – GEI) FIELD_STRUCT_DESC: 24-inch corrugated metal storm drainage pipe (CMP) through the levee, 4.0 feet below the crown. Flap gate on the waterside (WS) end. Concrete U-shaped headwalls on both ends. Cobble grouted outlet on the WS. Cobble grouted intake on the landside (LS). [Additional Reference(s): DWR Levee Log, 1987, (HLM 15.90). USACE San Joaquin O&M Manual 612.2, 1967, (HLM 15.90), 24-inch pipe listed]. FS Date: 2/26/2021

LS view: LS headwall at toe from crown.

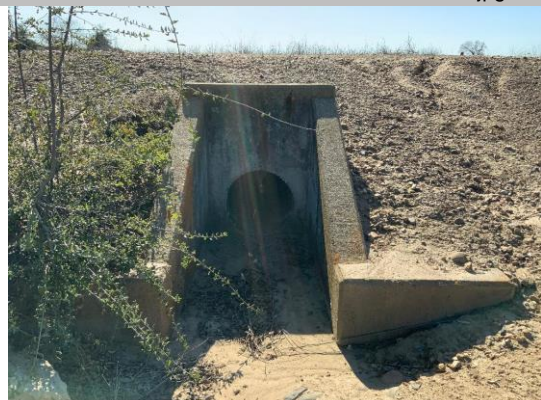
Photo 2 of 3 : UCIP_FA_2023_78979_92921.jpg

LS view: LS headwall at toe.

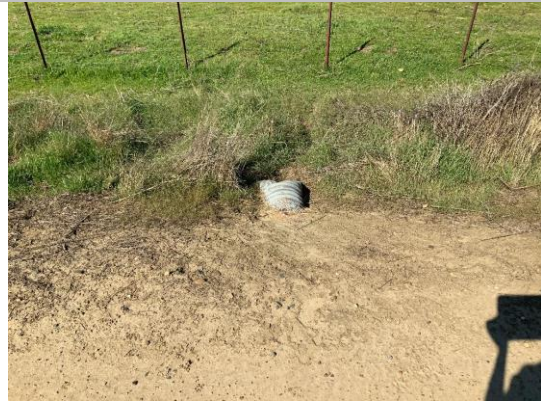
Photo 1 of 3 : UCIP_FA_2023_78980_92931.jpg

Comment Code					
Inspector Comment					
DS_ID:23612 FS_ID:78980 EP_NO: N/A Repair Type: Non-Urgent EVAL Issue: 11, Maintenance Compliance Issue Crossing Status: Found UCIP Comments: 02/26/2021 Record remains Non-Urgent. Unit 7 – Bear Creek (CLM 15.50 to 16.13) is considered a patrol road/high ground area with no defined levee prism, any issue found between CLM 15.50 to 16.13 of Unit 7 will be considered a maintenance issue, or an unauthorized encroachment, or an abandoned encroachment. Current condition of pipe crossing does not impede access to patrol road/high ground area. Pipe is open on both ends and LS pipe edges are severely bent, recommend maintenance. No permit was found authorizing this encroachment. CVFPB will need to review crossing to determine owner. The UCIP inspection was completed with LMA representative, J. Caruso. (H. Dunn - GEI) 09/18/2018 Levee is so short that it's almost nonexistent. Pipe goes just under levee and acts as an open storm drain. Inlet is bent down. There is a flooding potential because this pipe is open and goes straight through the levee; therefore, this crossing remains "Urgent." (A. McDonald - DWR UCIP)04/20/2017 Pipe is open on both ends. Requires a positive closure device. Crossing has been upgraded from No Action Needed to Urgent. (K. Fazel - UCIP) FIELD_STRUCT_DESC: 12-inch corrugated metal drainage culvert pipe (CMP) through the levee, 1.5 feet below the crown. Cobble grouted outlet on the waterside (WS). Open on both ends. [Additional Reference(s): DWR Levee Log, 1987, (HLM 16.09). USACE San Joaquin O&M Manual 612.2, 1967, (HLM 16.10), 12-inch pipe listed]. FS Date: 2/26/2021

LS view: LS pipe at toe from crown.

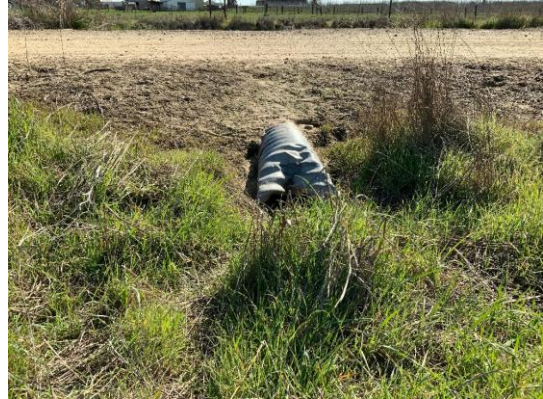
Photo 2 of 3 : UCIP_FA_2023_78980_92924.jpg

LS view: LS pipe at toe.

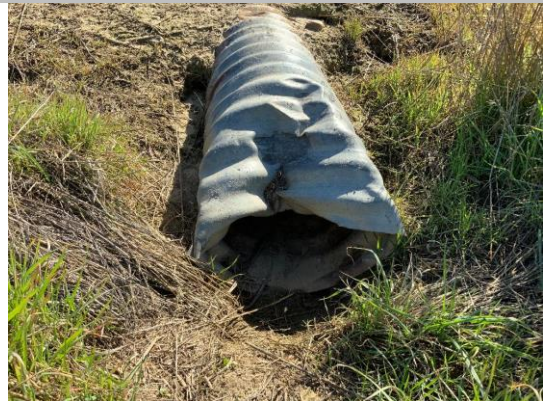
Photo 3 of 3 : UCIP_FA_2023_78980_92925.jpg

LS view: LS pipe, severely bent.
