**Flood Control Project Maintenance
Levee Inspections**

Maintenance Issue Types Only, Levee Inspection Report By Mile - Fall 2023

San Joaquin County Flood Control and Water Conservation District

Waterway	Bank	Unit Miles	Inspection Start/End	Inspector
Unit No. 01 Littlejohn Creek	Left	2.59	10/20/2023 10/20/2023	Alberto De Leon

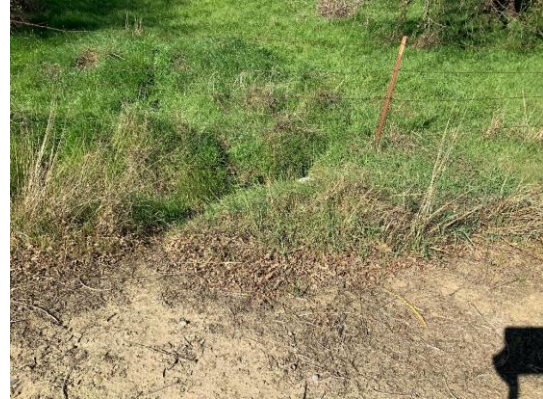
Photo 1 of 3 : UCIP_FA_2023_78934_92948.jpg

Comment Code						
Inspector Comment						
DS_ID:23614 FS_ID:78934 EP_NO: N/A Repair Type: Non-Urgent EVAL Issue: 11, Maintenance Compliance Issue Crossing Status: Found UCIP Comments: 02/26/2021 Record remains Non-Urgent. Unit 7 – Bear Creek (CLM 15.50 to 16.13) is considered a patrol road/high ground area with no defined levee prism, any issue found between CLM 15.50 to 16.13 of Unit 7 will be considered a maintenance issue, or an unauthorized encroachment, or an abandoned encroachment. Pipe is barely a foot below crown and open on both WS and LS toes. WS has bad erosion and large burrow holes under and around it, recommend maintenance for open pipe and erosion. Pipe is surrounded by large pieces of broken concrete. No permit was found authorizing this encroachment. CVFPB will need to review crossing to determine owner. The UCIP inspection was completed with LMA representative, J. Caruso. (H. Dunn – GEI) 009/18/2018 Levee is so short that it's almost nonexistent. Pipe goes just under levee and acts as an open storm drain. There is a flooding potential because this pipe is open and goes straight through the levee; therefore, this crossing remains "Urgent." (A. McDonald - DWR UCIP)04/20/2017 Pipe is open on both ends. Requires a positive closure device. Crossing has been upgraded from No Action Needed to Urgent. (K. Fazel - UCIP) FIELD_STRUCT_DESC: 12-inch corrugated metal drainage culvert pipe (CMP) through the levee, 2.0 feet below the crown. Cobble grouted outlet on the waterside (WS). Open on both ends. [Additional Reference(s): DWR Levee Log, 1987, (HLM 16.32). USACE San Joaquin O&M Manual 612.2, 1967, (HLM 16.32), 12-inch pipe listed]. FS Date: 2/26/2021

LS view: LS pipe at toe from crown.

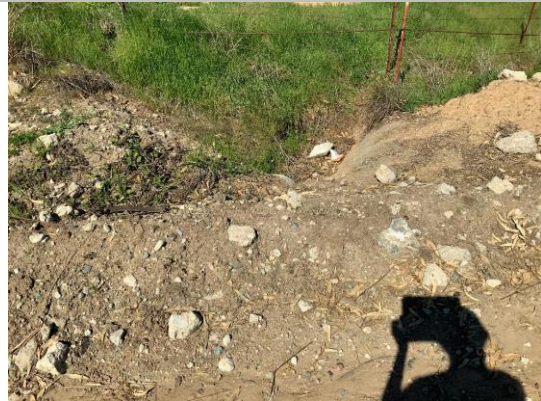
Photo 1 of 3 : UCIP_FA_2023_78935_92986.jpg

Comment Code						
Inspector Comment						
DS_ID:23618 FS_ID:78935 EP_NO: N/A Repair Type: Non-Urgent EVAL Issue: 5, Pipe Damage Crossing Status: Found UCIP Comments: 02/26/2021 Record remains Non-Urgent. DWR DMP has found integrity issues, LOF between 4 and 5. Crossing will be monitored until funding becomes available to address. Both ends open, no flap gate. LS pipe edges warped and filled with sediment. Current condition of pipe crossing does not impede access to patrol road/high ground area. No permit was found authorizing this encroachment. CVFPB will need to review crossing to determine owner. The UCIP inspection was completed with LMA representative, J. Caruso. (H. Dunn – GEI) 05/12/2014 Silt buildup in pipe at outlet. (W. Wylie - DWR UCIP) FIELD_STRUCT_DESC: 18-inch corrugated metal drainage pipe (CMP) through the levee, 1.5 feet below the crown. Cobble grouted outlet on the waterside (WS). Open on both ends. [Additional Reference(s): DWR Levee Log, 1987, (HLM 16.69). USACE San Joaquin O&M Manual, Unit 612.2, 1967, Revised 26 March 2010, (HLM 16.73), listed as two 18-inch pipes. USACE As-Built Drawing No. CA -3-4-19, 15 March 1965, Sheet 25, STA 895+00, listed as 18-inch pipe]. FS Date: 2/26/2021

LS pipe at toe from crown.

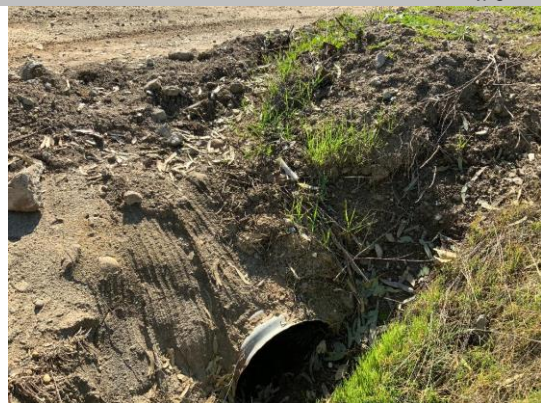
Photo 2 of 3 : UCIP_FA_2023_78935_92987.jpg

LS pipe slope.

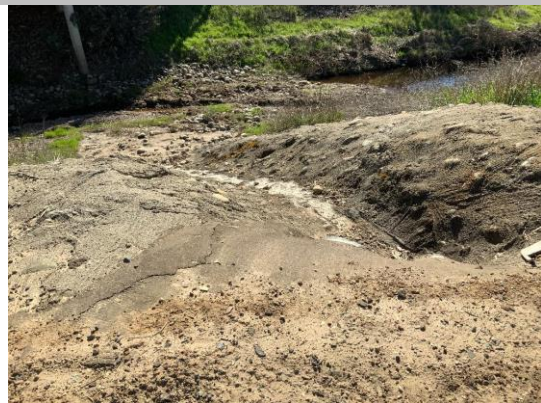
Photo 1 of 3 : UCIP_FA_2023_78936_92996.jpg

DS_ID:23617
FS_ID:78936
EP_NO: N/A
Repair Type: No Action Needed
EVAL Issue:
Crossing Status: Found
UCIP Comments: 02/26/2021 Record updated from Non-Urgent to No Action Needed. DWR DMP internal inspection has not found pipe integrity issues. LOF of crossing is less or equal to 4.0. Recommend next video inspection in 5 years. Minor warping on edges of both LS and WS pipes. Both ends open, no flap gate. Current condition of pipe crossing does not impede access to patrol road/high ground area. No permit was found authorizing this encroachment. CVFPB will need to review crossing to determine owner. The UCIP inspection was completed with LMA representative, J. Caruso. (H. Dunn – GEI)

05/12/2014 No Flapgate. (W. Wylie - DWR UCIP)
FIELD_STRUCT_DESC: 21-inch corrugated metal drainage pipe (CMP) through the levee, 1.5 feet below the crown. Cobble grouted outlet on the waterside (WS). Pipe passes through the levee at an angle. Open on both ends. [Additional Reference(s): DWR Levee Log, 1987, (HLM 16.69), 14-inch pipe listed. USACE San Joaquin O&M Manual, Unit 612.2, 1967, Revised 26 March 2010, (HLM 16.73), listed as two 18-inch pipes. USACE As-Built Drawing No. CA -3-4-19, 15 March 1965, Sheet 25, STA 895+00, listed as 14-inch pipe].
FS Date: 2/26/2021

WS view: WS pipe from crown.

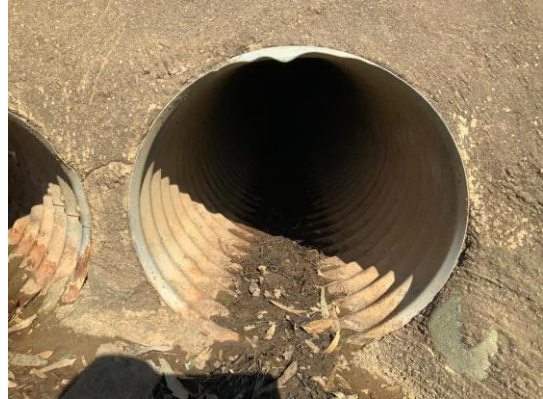
Photo 2 of 3 : UCIP_FA_2023_78936_92997.jpg

WS view: WS pipe, minor warping of edges and no flapgate.

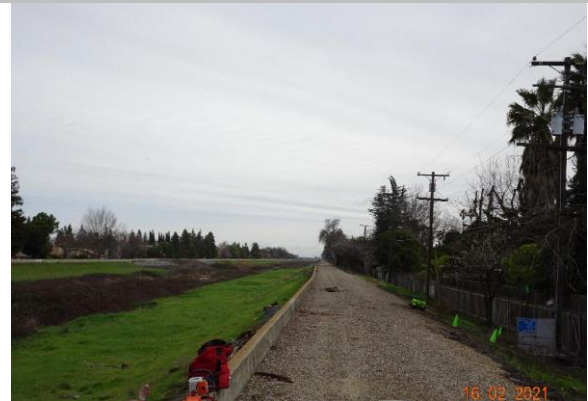
Photo 1 of 3 : UCIP_FA_2023_78438_93420.jpg

Comment Code					
Inspector Comment					
DS_ID:23731 FS_ID:78438 EP_NO: N/A Repair Type: Non-Urgent EVAL Issue: Crossing Status: Found UCIP Comments: 02/16/2021 Record was updated from No Action Needed to Non-Urgent. No permit was found authorizing this encroachment. CVFPB will need to review crossing to determine owner. Briar bush overgrowth limiting visual of WS toe. Working meter and control panel belonging Rancho San Joaquin Maintenance District Storm Water Facility at LS toe. LMA representative indicated utility belongs to the City of Stockton. The UCIP inspection was completed with DWR Inspector, O. Magana, and LMA representative, J. Caruso. (N. Cholewinski - GEI) FIELD_STRUCT_DESC: [Rancho San Joaquin Maintenance District Storm Water Facility] 1 of 2: 10-inch soil proofed steel drainage pipe through the levee, 3.0 feet below the crown. Flap gates on the waterside (WS) end. Siphon breaker inside a 24-inch corrugated metal pipe (CMP) riser unit on the WS slope. Pumps mounted over a 6-foot by 7-foot concrete sump at the landside (LS) toe. Pole and electrical panel at the same location. [Additional Reference(s): DWR Levee Log, 1990, (HLM 2.18). USACE San Joaquin O&M Manual 612.1, June 1965, (HLM 2.18), 10-inch pipe listed]. FS Date: 2/16/2021

Crown Overview

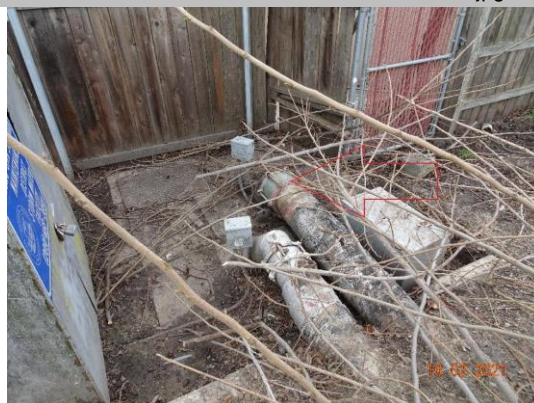
Photo 2 of 3 : UCIP_FA_2023_78438_93422.jpg

LS View: Pipe visible at LS toe. Electrical control panel and post adjacent to utility.

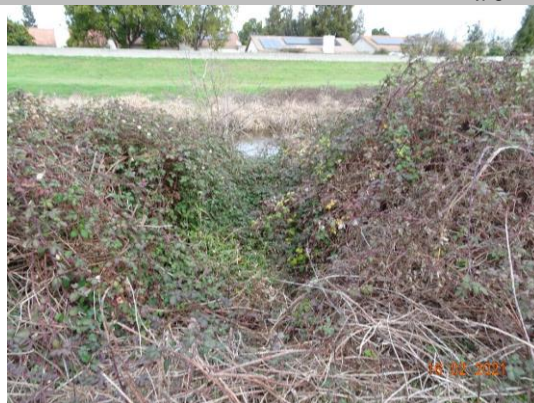
Photo 3 of 3 : UCIP_FA_2023_78438_93426.jpg

WS View: Briar bush overgrowth limiting visual of WS toe.

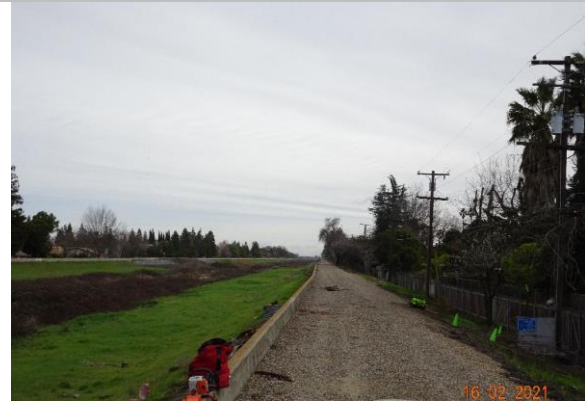
Photo 1 of 3 : UCIP_FA_2023_78439_93411.jpg

Comment Code						
Inspector Comment						
DS_ID:23821 FS_ID:78439 EP_NO: N/A Repair Type: Non-Urgent EVAL Issue: Crossing Status: Found UCIP Comments: 02/16/2021 Record was updated from No Action Needed to Non-Urgent. No permit was found authorizing this encroachment. CVFPB will need to review crossing to determine owner. Briar bush overgrowth limiting visual of WS toe. Working meter and control panel belonging Rancho San Joaquin Maintenance District Storm Water Facility at LS toe. LMA representaitve indicated utility belongs to the City of Stockton. The UCIP inspection was completed with DWR Inspector, O. Magana, and LMA representative, J. Caruso. (N. Cholewinski - GEI) FIELD_STRUCT_DESC: [Rancho San Joaquin Maintenance District Storm Water Facility] 2 of 2: 10-inch soil proofed steel drainage pipe through the levee, 3.0 feet below the crown. Flap gate on the waterside (WS) end. Siphon breaker inside a 24-inch corrugated metal pipe (CMP) riser unit on the WS shoulder. Pumps mounted over a 6-foot by 7-foot concrete sump at the landside (LS) toe. [Additional Reference(s): DWR Levee Log, 1990, (HLM 2.18). USACE San Joaquin O&M Manual 612.1, June 1965, (HLM 2.18), 10-inch pipe listed]. FS Date: 2/16/2021

Crown Overview

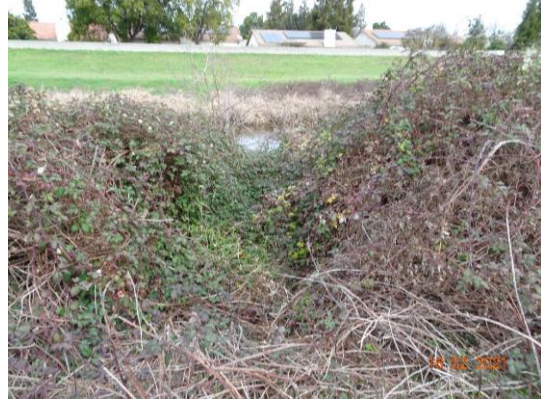
Photo 3 of 3 : UCIP_FA_2023_78439_93419.jpg

WS View: Briar bush overgrowth limiting visual of WS toe.

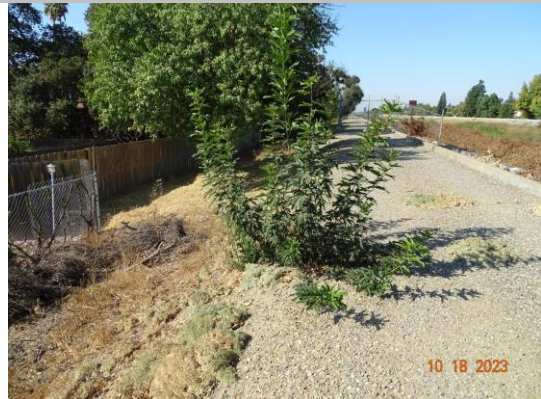
Photo 1 of 1 : FA_2023_NA0017_152_100_20231101_00256.jpg

LM Start	2.37	Rating **	U	Issue No.	100
LM End	2.37	Issue Type +	Ma	Location *	LS
Category	Earthen Levee			GPS Latitude/Longitude	
				Start	End
Item	Vegetation			38.042717°	38.042717°
				-121.340806°	-121.340806°
DWR ID	DWR_NA0017_08_s_2023_100				
Comment Code					
V2 : Remove the wild growth and woody vegetation other than native grasses from the levee slopes.					
Inspector Comment					
A tree sapling is along the landside shoulder.

View of tree sapling along the landside slope. Fall 2023

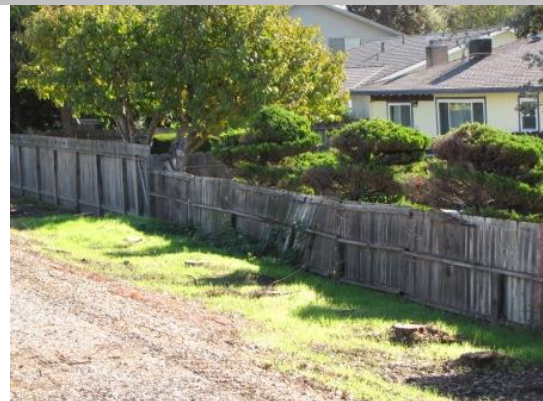
Photo 1 of 1 : FA_2023_NA0017_152_12_20230905_00003.jpg

LM Start	2.50	Rating **	N	Issue No.	12
LM End	2.50	Issue Type +	Ma	Location *	LS
Category	Earthen Levee			GPS Latitude/Longitude	
				Start	End
Item	Trim / Thin Trees			38.042749°	38.042749°
				-121.338402°	-121.338402°
DWR ID	DWR_NA0017_08_s_2012_12				
Comment Code					
T5 : Tree stumps.					
Inspector Comment

View of stumps along the landward toe looking upstream.

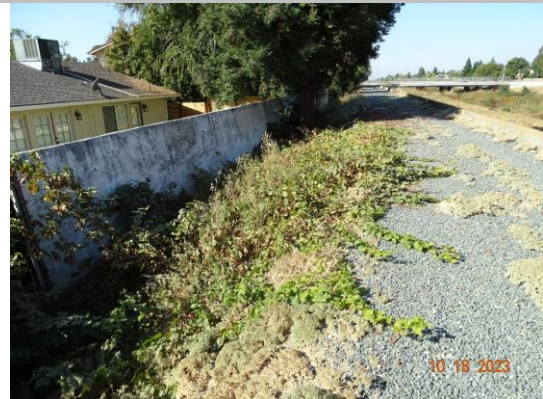
Photo 1 of 1 : FA_2023_NA0017_152_188_20231101_00255.jpg

LM Start	2.94	Rating **	U	Issue No.	188
LM End	2.94	Issue Type +	Ma	Location *	LS
Category	Earthen Levee			GPS Latitude/Longitude	
				Start	End
Item	Vegetation			38.042670°	38.042670°
				-121.330222°	-121.330222°
DWR ID	DWR_NA0017_08_f_2022_188				
Comment Code					
V2 : Remove the wild growth and woody vegetation other than native grasses from the levee slopes.					
Inspector Comment

View of wild growth vegetation along the landside slope. Fall 2023

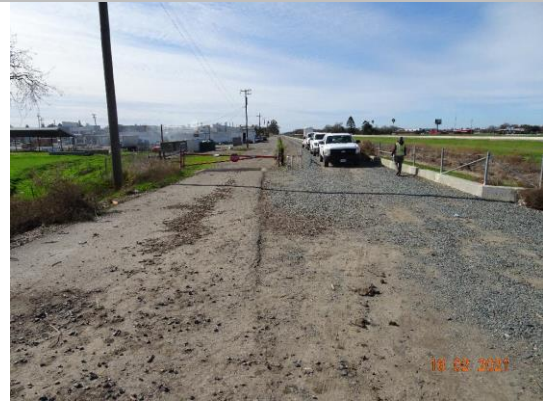
Photo 1 of 3 : UCIP_FA_2023_78983_93342.jpg

Crown Overview

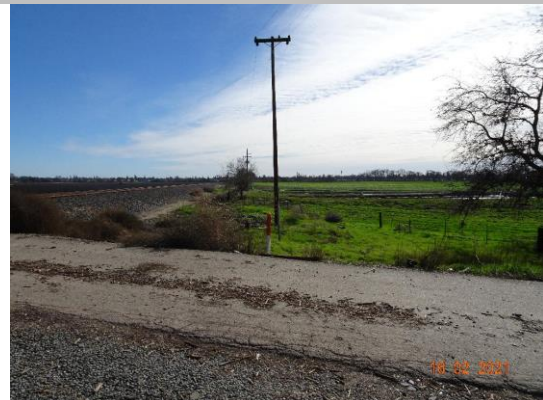
Photo 2 of 3 : UCIP_FA_2023_78983_93344.jpg

LS View: Headwall at LS toe.

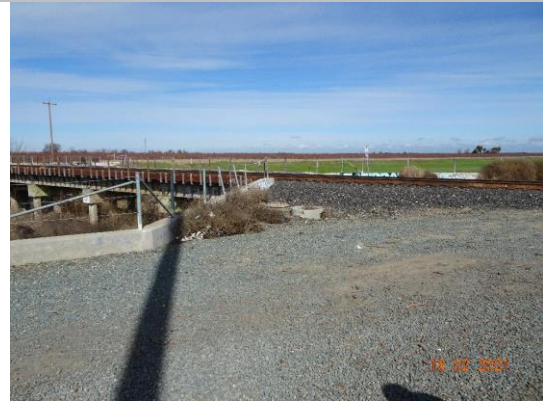
Photo 3 of 3 : UCIP_FA_2023_78983_93346.jpg

WS View

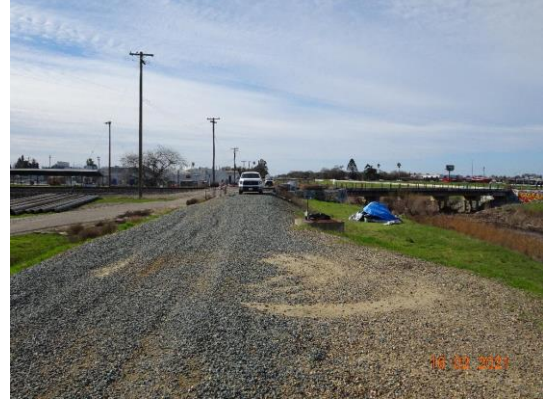
Photo 1 of 3 : UCIP_FA_2023_78443_93324.jpg

Crown Overview

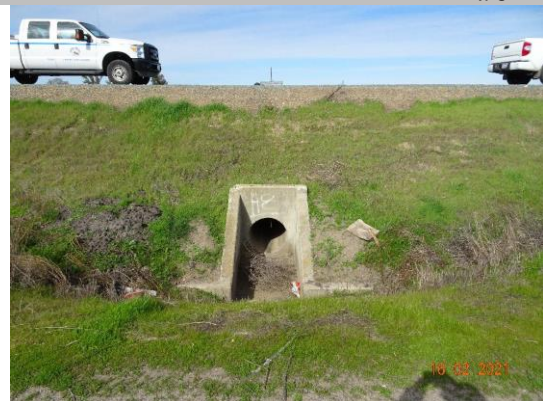
Photo 2 of 3 : UCIP_FA_2023_78443_93330.jpg

LS View: Headwall at LS toe.

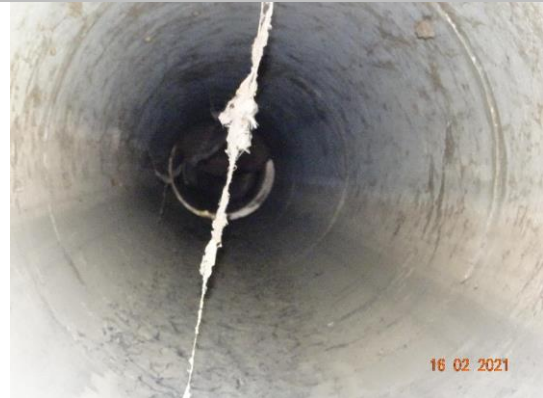
Photo 3 of 3 : UCIP_FA_2023_78443_93331.jpg

LS View: Inside pipe at LS toe.

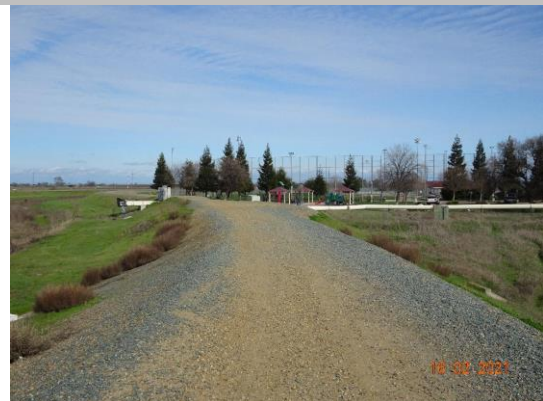
Photo 1 of 3 : UCIP_FA_2023_78985_93307.jpg

Crown Overview

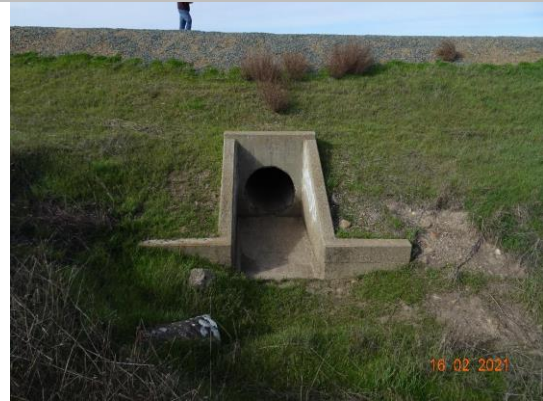
Photo 2 of 3 : UCIP_FA_2023_78985_93309.jpg

LS View: Headwall at LS toe.

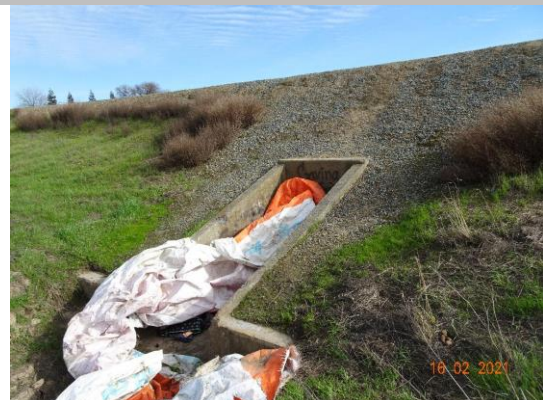
Photo 3 of 3 : UCIP_FA_2023_78985_93313.jpg

WS View: Headwall and flapgate at WS slope. Debris present.

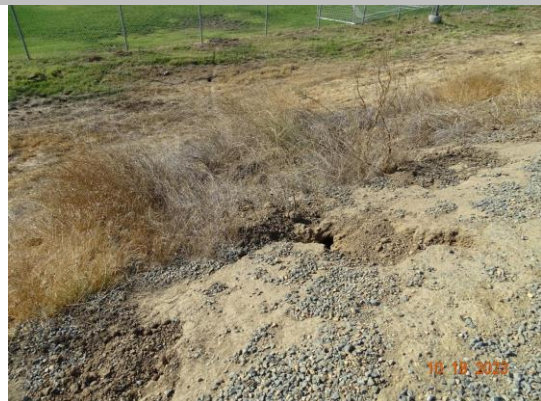
Photo 1 of 1 : FA_2023_NA0017_152_145_20231101_00254.jpg

LM Start	4.79	Rating **	U	Issue No.	145
LM End	4.80	Issue Type +	Ma	Location *	LS
Category	Earthen Levee			GPS Latitude/Longitude	
				Start	End
Item	Animal Control			38.043893°	38.043907°
				-121.296922°	-121.296700°
DWR ID	DWR_NA0017_08_f_2020_145				
Comment Code					
A3 : No rodents visible, but rodent burrows visible; need to backfill and compact or grout burrows.					
Inspector Comment

View of large animal burrow along the landside slope. Fall 2023

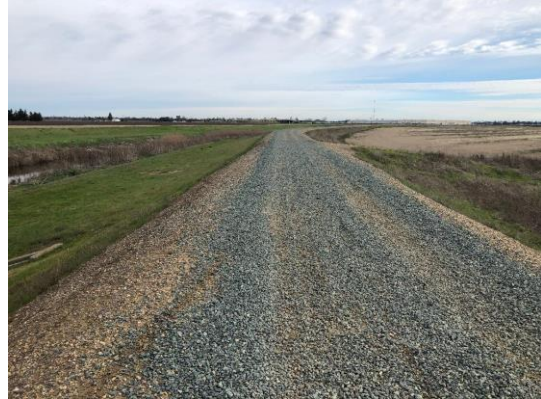
Photo 1 of 3 : UCIP_FA_2023_78987_93243.jpg

Crown Overview

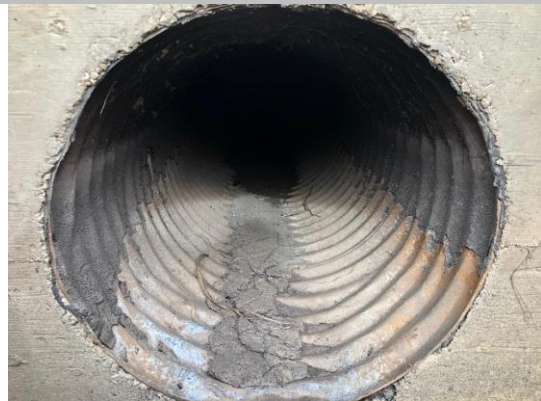
Photo 2 of 3 : UCIP_FA_2023_78987_93246.jpg

LS View: Pipe at LS toe.

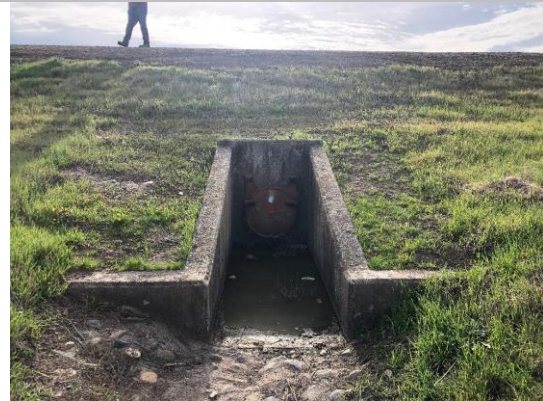
Photo 3 of 3 : UCIP_FA_2023_78987_93249.jpg

WS View: Headwall and flapgate at WS slope.

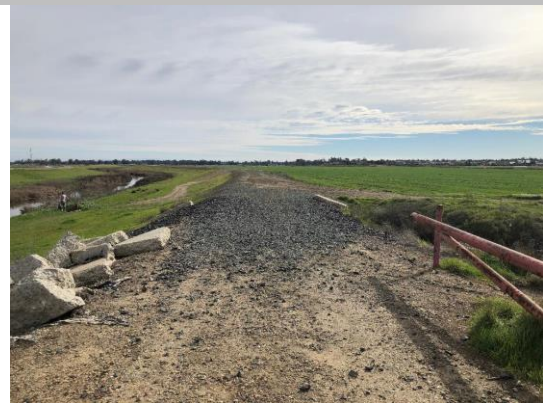
Photo 1 of 3 : UCIP_FA_2023_78988_93221.jpg

Crown Overview

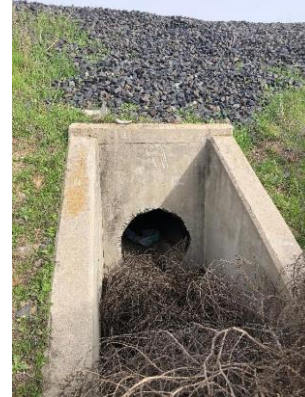
Photo 2 of 3 : UCIP_FA_2023_78988_93223.jpg

LS View: Headwall at LS toe.

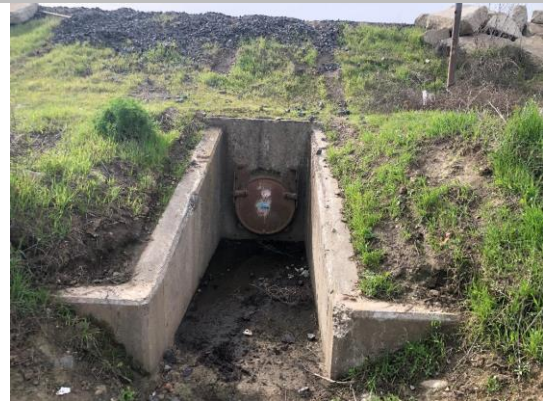
Photo 3 of 3 : UCIP_FA_2023_78988_93226.jpg

WS View: Headwall and 24-inch flapgate at WS toe.

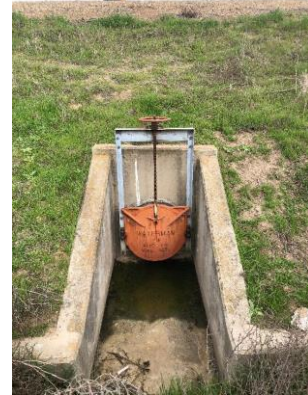
Photo 1 of 3 : UCIP_FA_2023_78989_93180.jpg

LS View: Headwall with slide gate at LS toe.

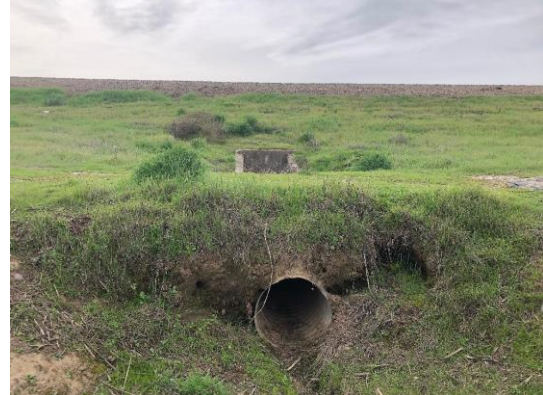
Photo 2 of 3 : UCIP_FA_2023_78989_93181.jpg

WS View: Headwall and flapgate at WS slope with pipe through WS berm.

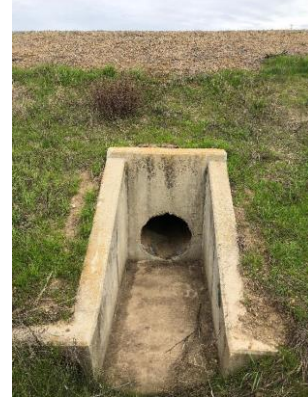
Photo 2 of 3 : UCIP_FA_2023_78990_93169.jpg

LS View: Headwall at LS toe.

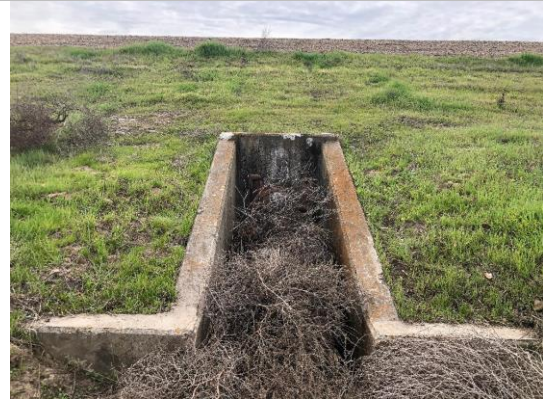
Photo 3 of 3 : UCIP_FA_2023_78990_93172.jpg

WS View: Headwall and flapgate at WS slope.

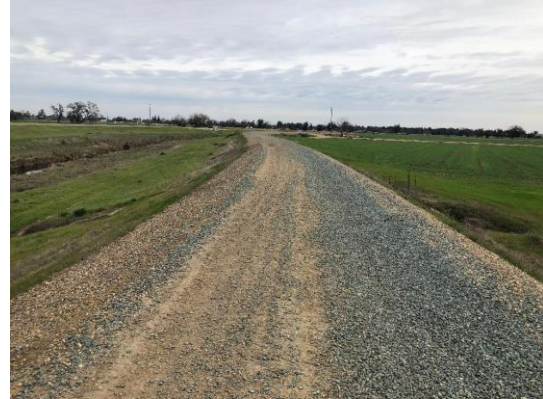
Photo 1 of 3 : UCIP_FA_2023_78991_93159.jpg

Crown Overview

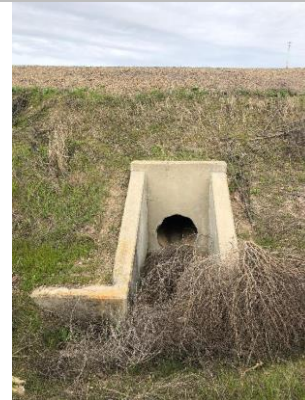
Photo 2 of 3 : UCIP_FA_2023_78991_93161.jpg

LS View: Headwall at LS toe.

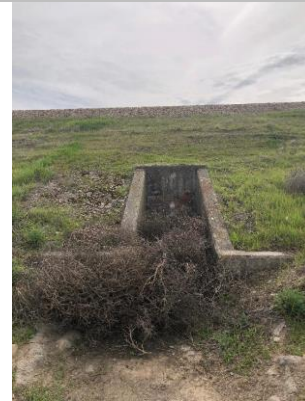
Photo 3 of 3 : UCIP_FA_2023_78991_93165.jpg

WS View: Headwall and flapgate at WS slope.

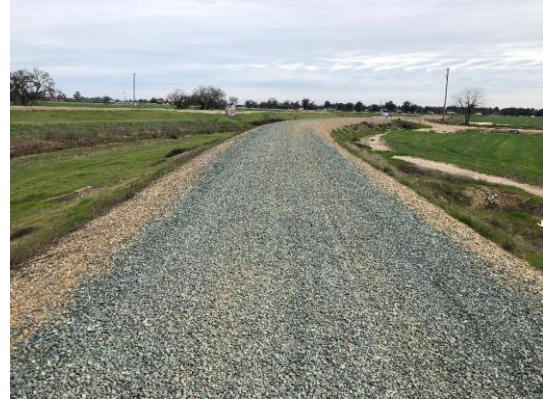
Photo 1 of 3 : UCIP_FA_2023_78992_93152.jpg

Crown Overview

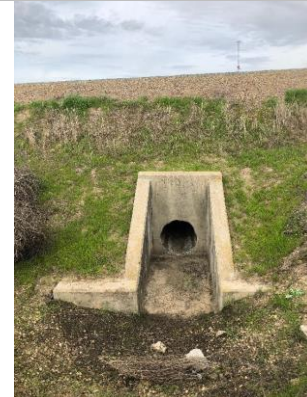
Photo 2 of 3 : UCIP_FA_2023_78992_93154.jpg

LS View: Headwall at LS toe.

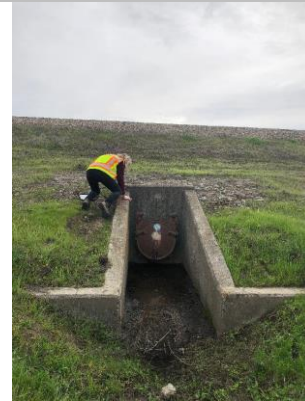
Photo 3 of 3 : UCIP_FA_2023_78992_93157.jpg

WS View: Headwall and flapgate at WS slope.

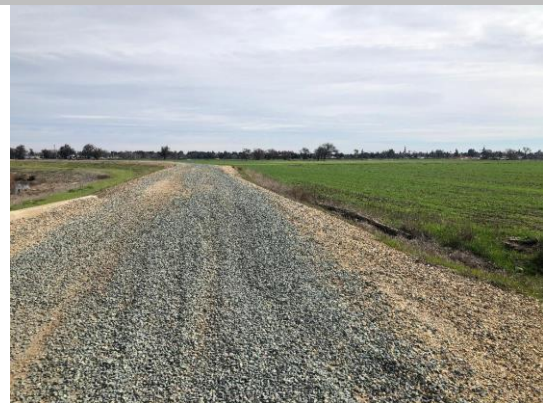
Photo 1 of 3 : UCIP_FA_2023_78993_93140.jpg

Crown Overview

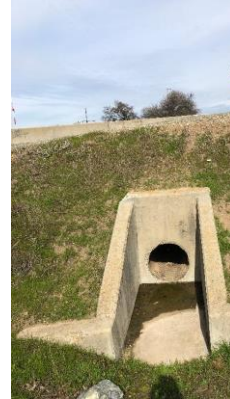
Photo 2 of 3 : UCIP_FA_2023_78993_93142.jpg

LS View: Headwall at LS toe.

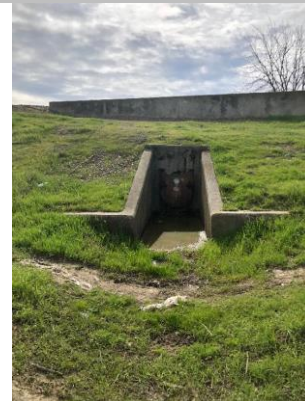
Photo 3 of 3 : UCIP_FA_2023_78993_93145.jpg

WS View: Headwall and flapgate at WS slope.

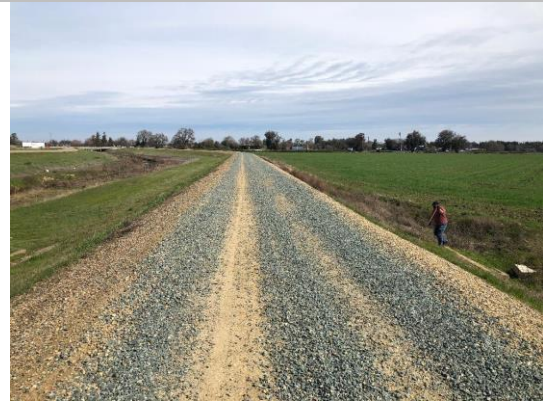
Photo 1 of 3 : UCIP_FA_2023_78994_93130.jpg

Comment Code					
Inspector Comment					
DS_ID:23719 FS_ID:78994 EP_NO: N/A Repair Type: Non-Urgent EVAL Issue: Crossing Status: Found UCIP Comments: 02/18/2021 Record was updated from No Action Needed to Non-Urgent. No permit was found authorizing this encroachment. CVFPB will need to review crossing to determine owner. DWR DMP has not found internal issues, LOF between 1 and 2. Recommend inspection in 5 years. The UCIP inspection was completed with DWR Inspector, S. Donovan, and LMA representative, J. Caruso. (N. Cholewinski - GEI) FIELD_STRUCT_DESC: 1 of 2: 30-inch corrugated metal storm drainage pipe (CMP) through the levee, 8.3 feet below the crown. Concrete U-shaped headwalls on both ends. Flap gate on the waterside (WS) end. Grouted intake on the landside (LS). Cobble grouted outlet across the berm. [Additional Reference(s): DWR Levee Log, 1990, (HLM 7.00). USACE San Joaquin O&M Manual 612.1, June 1965, (HLM 7.00), and 612 (addendum), February 1999, (HLM 7.10), (Station 374+70), 30-inch pipe listed]. FS Date: 2/18/2021

Crown Overview

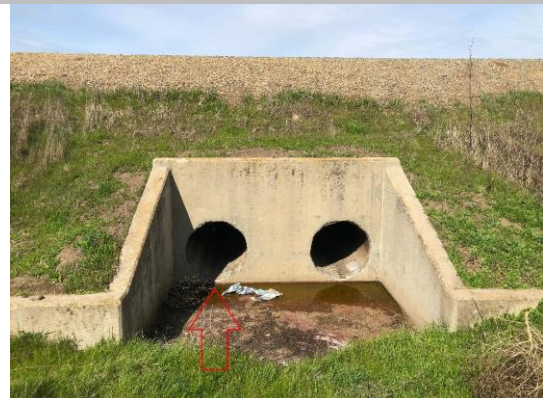
Photo 2 of 3 : UCIP_FA_2023_78994_93132.jpg

LS View: Headwall at LS toe.

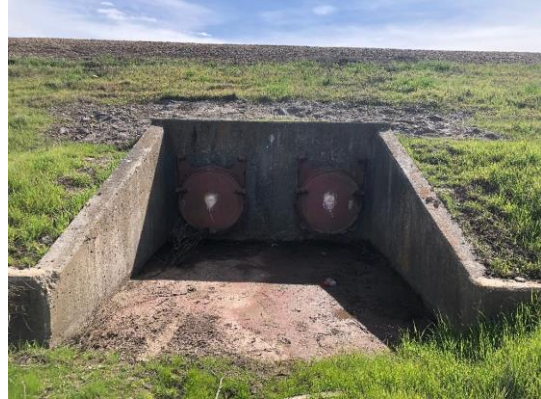
Photo 3 of 3 : UCIP_FA_2023_78994_93135.jpg

WS View: Headwall and flapgate at WS slope.

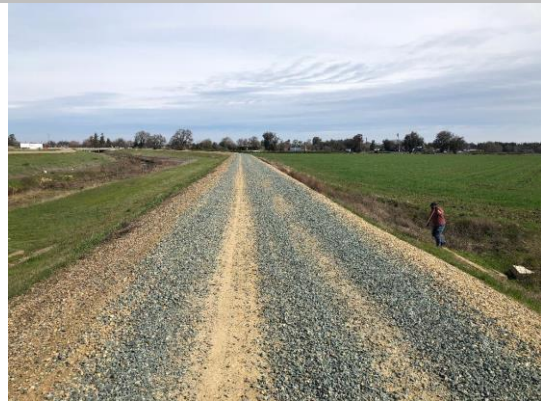
Photo 1 of 3 : UCIP_FA_2023_78995_93123.jpg

DS_ID:23812
 FS_ID:78995
 EP_NO: N/A
 Repair Type: Non-Urgent
 EVAL Issue:
 Crossing Status: Found
 UCIP Comments: 02/18/2021 Record was updated from No Action Needed to Non-Urgent. No permit was found authorizing this encroachment. CVFPB will need to review crossing to determine owner. DWR DMP has not found internal issues, LOF between 1 and 2. Recommend inspection in 5 years. The UCIP inspection was completed with DWR Inspector, S. Donovan, and LMA representative, J. Caruso. (N. Cholewinski - GEI)
 FIELD_STRUCT_DESC: 2 of 2: 30-inch corrugated metal storm drainage pipe (CMP) through the levee, 8.3 feet below the crown. Concrete U-shaped headwalls on both ends. Flap gate on the waterside (WS) end. Grouted intake on the landside (LS). Cobble grouted outlet across the berm. [Additional Reference(s): DWR Levee Log, 1990, (HLM 7.00). USACE San Joaquin O&M Manual 612.1, June 1965, (HLM 7.00), and 612 (addendum), February 1999, (HLM 7.10), (Station 374+70), 30-inch pipe listed].

Crown Overview

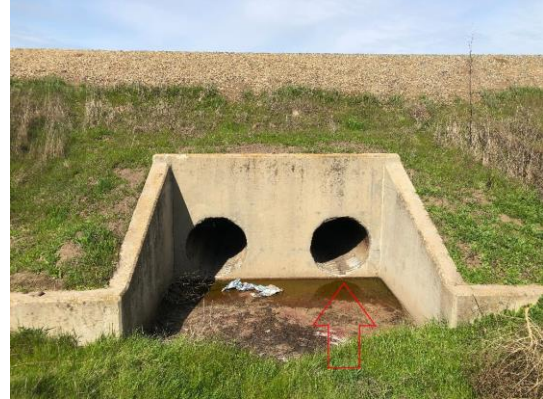
Photo 2 of 3 : UCIP_FA_2023_78995_93125.jpg

LS View: Headwall at LS toe.

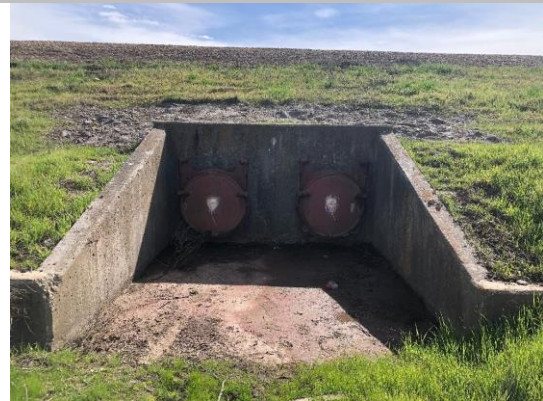
Photo 3 of 3 : UCIP_FA_2023_78995_93128.jpg

WS View: Headwall and flapgate at WS slope.

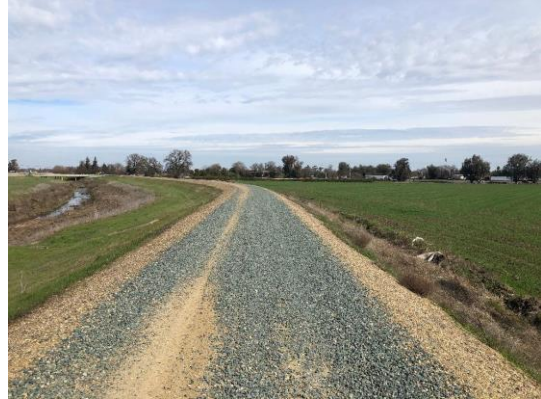
Photo 1 of 3 : UCIP_FA_2023_78996_93117.jpg

Comment Code						
Inspector Comment						
DS_ID:23720 FS_ID:78996 EP_NO: N/A Repair Type: Non-Urgent EVAL Issue: Crossing Status: Found UCIP Comments: 02/18/2021 Record was updated from No Action Needed to Non-Urgent. No permit was found authorizing this encroachment. CVFPB will need to review crossing to determine owner. DWR DMP has not found internal issues, LOF between 1 and 2. Recommend inspection in 5 years. The UCIP inspection was completed with DWR Inspector, S. Donovan, and LMA representative, J. Caruso. (N. Cholewinski - GEI) FIELD_STRUCT_DESC: 36-inch corrugated metal storm drainage pipe (CMP) through the levee, 6.5 feet below the crown. Concrete U-shaped headwalls on both ends. Flap gate on the waterside (WS) end. Grouted intake on the landside (LS). Cobble grouted outlet across the berm. [Additional Reference(s): DWR Levee Log, 1990, (HLM 7.07). USACE San Joaquin O&M Manual 612.1, June 1965, (HLM 7.07), and 612 (addendum), February 1999, (HLM 7.18), (Station 379+00), 36-inch pipe listed]. FS Date: 2/18/2021

Crown Overview

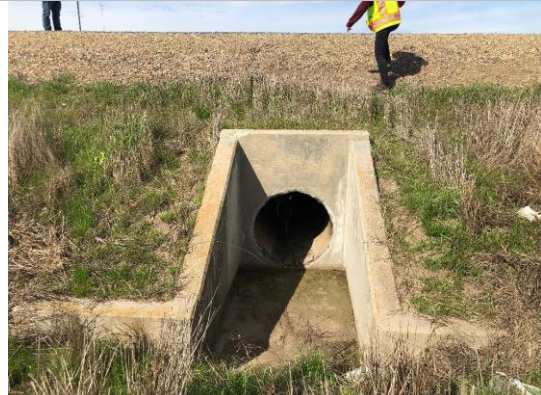
Photo 2 of 3 : UCIP_FA_2023_78996_93119.jpg

LS View: Headwall at LS toe.

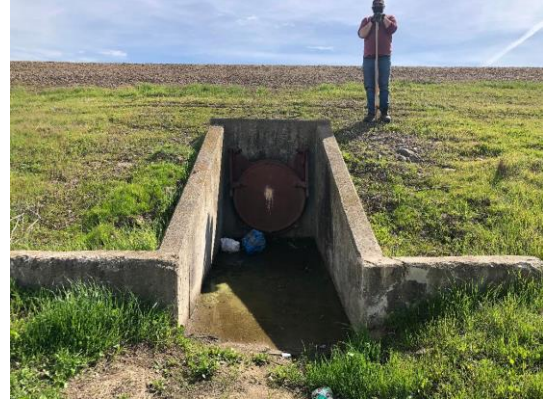
Photo 3 of 3 : UCIP_FA_2023_78996_93122.jpg

WS View: Headwall and flapgate at WS slope.

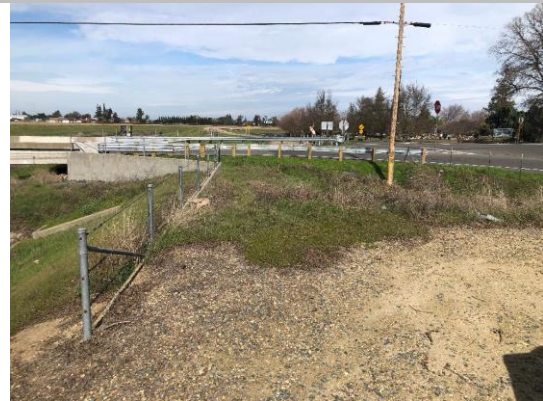
Photo 1 of 3 : UCIP_FA_2023_78997_93109.jpg

DS_ID:23721
 FS_ID:78997
 EP_NO: N/A
 Repair Type: Non-Urgent
 EVAL Issue:
 Crossing Status: Found
 UCIP Comments: 02/18/2021 Record was updated from No Action Needed to Non-Urgent. No permit was found authorizing this encroachment. CVFPB will need to review crossing to determine owner. DWR DMP has not found internal issues, LOF between 1 and 2. Recommend inspection in 5 years. The UCIP inspection was completed with DWR Inspector, S. Donovan, and LMA representative, J. Caruso. (N. Cholewinski - GEI)
 FIELD_STRUCT_DESC: 36-inch corrugated metal storm drainage pipe (CMP) through the levee, 6.8 feet below the crown. Concrete U-shaped headwalls on both ends. Flap gate on the waterside (WS) end. Grouted intake on the landside (LS). Cobble grouted outlet across the berm.
 [Additional Reference(s): DWR Levee Log, 1990, (HLM 7.26). USACE San Joaquin O&M Manual 612.1, June 1965, (HLM 7.26), and 612 (addendum), February 1999, (HLM 7.34), (Station 387+80), 36-inch pipe listed].

Crown Overview

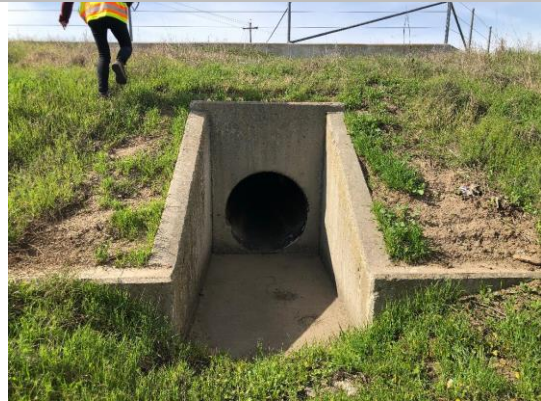
Photo 2 of 3 : UCIP_FA_2023_78997_93111.jpg

LS View: Headwall at LS toe.

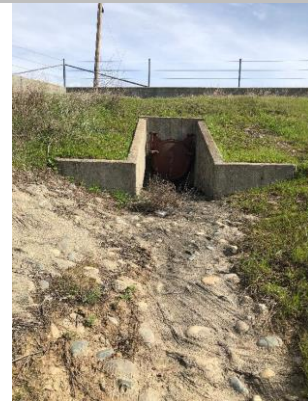
Photo 3 of 3 : UCIP_FA_2023_78997_93115.jpg

WS View: Headwall and flapgate at WS slope.

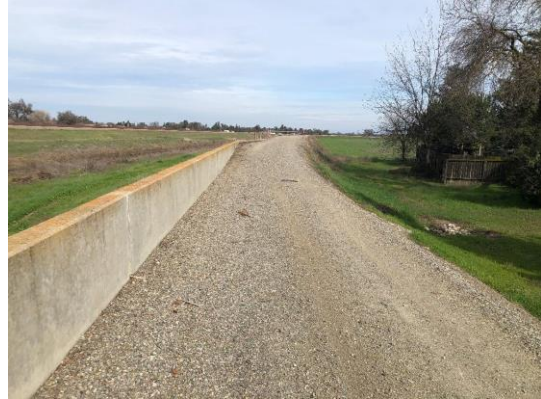
Photo 1 of 3 : UCIP_FA_2023_78999_93087.jpg

Comment Code						
Inspector Comment						
DS_ID:23743 FS_ID:78999 EP_NO: N/A Repair Type: Non-Urgent EVAL Issue: Crossing Status: Found UCIP Comments: 02/18/2021 Record remains Non-Urgent. No permit was found authorizing this encroachment. CVFPB will need to review crossing to determine owner. DWR DMP has not found internal issues, LOF between 1 and 2. Recommend inspection in 5 years. No cobbles observed in pipe at LS toe. The UCIP inspection was completed with DWR Inspector, S. Donovan, and LMA representative, J. Caruso. (N. Cholewinski - GEI)05/21/2014 Cobbles building up at inlet and inside pipe along with sediment. (W. Wylie - DWR UCIP) FIELD_STRUCT_DESC: 24-inch corrugated metal storm drainage pipe (CMP) through the levee, 7.0 feet below the crown. Flap gate on the waterside (WS) end. Concrete U-shaped headwalls on both ends. Cobble grouted outlet across the berm. Cobble grouted apron on the landside (LS) end. [Additional Reference(s): DWR Levee Log, 1990, (HLM 7.65). USACE San Joaquin O&M Manual 612.2, 1967, (HLM 7.65), and 612 (addendum), February 1999, (HLM 7.70), (Station 406+58), 24-inch pipe listed]. FS Date: 2/18/2021

Crown Overview

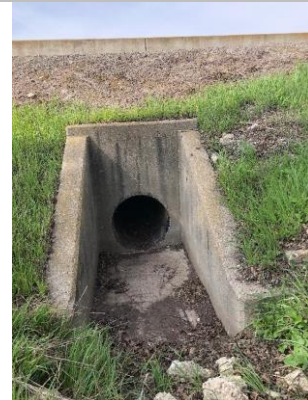
Photo 2 of 3 : UCIP_FA_2023_78999_93089.jpg

LS View: Headwall at LS toe.

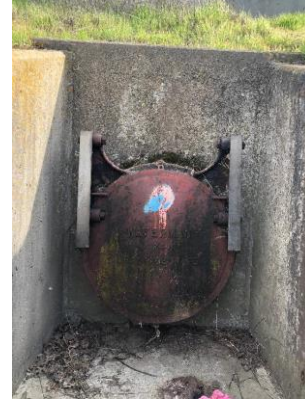
Photo 3 of 3 : UCIP_FA_2023_78999_93092.jpg

WS View: Headwall and 24-inch flapgate at WS slope.

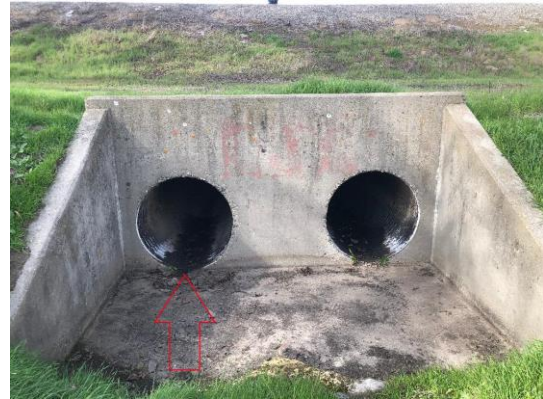
Photo 1 of 3 : UCIP_FA_2023_79000_93080.jpg

Comment Code					
Inspector Comment					
DS_ID:23744 FS_ID:79000 EP_NO: N/A Repair Type: Non-Urgent EVAL Issue: 4b, Safety Issue Crossing Status: Found UCIP Comments: 02/18/2021 Record remains Non-Urgent. No permit was found authorizing this encroachment. CVFPB will need to review crossing to determine owner. DWR DMP has not found internal issues, LOF between 1 and 2. Recommend inspection in 5 years. No lid on riser. Recommend adding lid to riser as a safety measure. The UCIP inspection was completed with DWR Inspector, S. Donovan, and LMA representative, J. Caruso. (N. Cholewinski - GEI)05/21/2014 Lid damaged/missing from CMP riser on WS slope. (W. Wylie - DWR UCIP) FIELD_STRUCT_DESC: 1 of 2: 36-inch corrugated metal storm drainage pipe (CMP) through the levee, 9.0 feet below the crown. Flap gate on the waterside (WS) end. Slide gate inside a 48-inch CMP riser unit on the WS slope. Concrete U-shaped headwalls on both ends. Cobble grouted outlet on the channel bank. Cobble grouted apron in ditch on the landside (LS). [Additional Reference(s): DWR Levee Log, 1990, (HLM 8.18). USACE San Joaquin O&M Manual 612.2, 1967, (HLM 8.18), and 612 (addendum), February 1999, (HLM 8.21), (Station 433+70), 36-inch pipe listed]. FS Date: 2/18/2021

LS View: Headwall at LS toe.

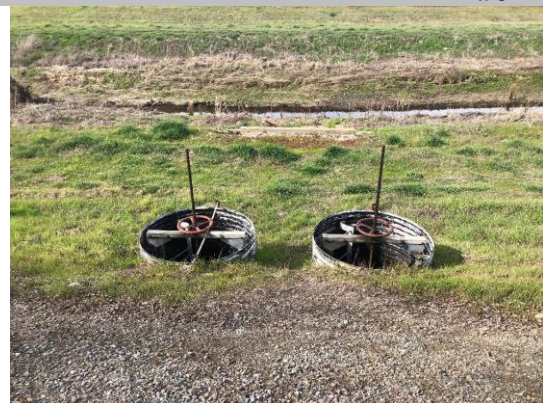
Photo 2 of 3 : UCIP_FA_2023_79000_93082.jpg

WS View: Riser on WS shoulder.

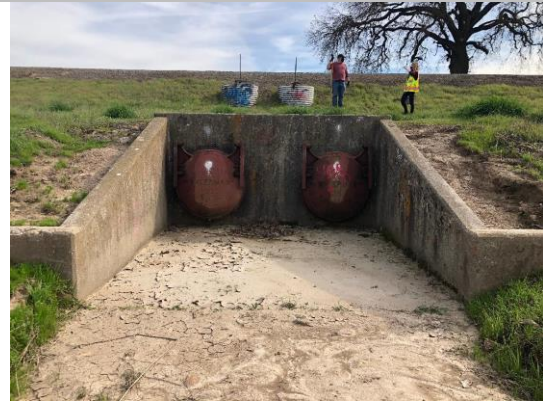
Photo 3 of 3 : UCIP_FA_2023_79000_93085.jpg

WS View: Headwall and flapgate at WS toe.

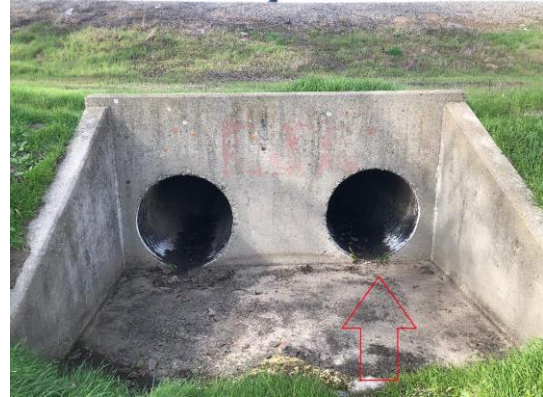
Photo 1 of 3 : UCIP_FA_2023_79001_93071.jpg

Comment Code						
Inspector Comment						
DS_ID:23820 FS_ID:79001 EP_NO: N/A Repair Type: Non-Urgent EVAL Issue: 4b, Safety Issue Crossing Status: Found UCIP Comments: 02/18/2021 Record remains Non-Urgent. No permit was found authorizing this encroachment. CVFPB will need to review crossing to determine owner. DWR DMP has not found internal issues, LOF between 1 and 2. Recommend inspection in 5 years. No lid on riser. Recommend adding lid to riser as a safety measure. The UCIP inspection was completed with DWR Inspector, S. Donovan, and LMA representative, J. Caruso. (N. Cholewinski - GEI)05/21/2014 Lid damaged/missing on 48-inch CMP riser on WS slope. (W. Wylie - DWR UCIP) FIELD_STRUCT_DESC: 2 of 2: 36-inch corrugated metal storm drainage pipe (CMP) through the levee, 9.0 feet below the crown. Flap gate on the waterside (WS) end. Slide gate inside a 48-inch CMP riser unit on the WS slope. Concrete U-shaped headwalls on both ends. Cobble grouted outlet on the channel bank. Cobble grouted apron in ditch on the landside (LS). [Additional Reference(s): DWR Levee Log, 1990, (HLM 8.18). USACE San Joaquin O&M Manual 612.2, 1967, (HLM 8.18), and 612 (addendum), February 1999, (HLM 8.21), (Station 433+70), 36-inch pipe listed]. FS Date: 2/18/2021

LS View: Headwall at LS toe.

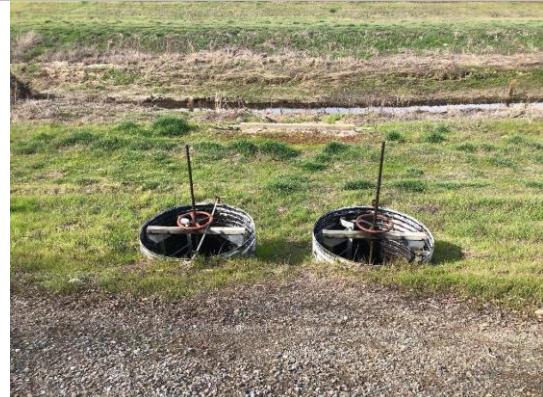
Photo 2 of 3 : UCIP_FA_2023_79001_93073.jpg

WS View

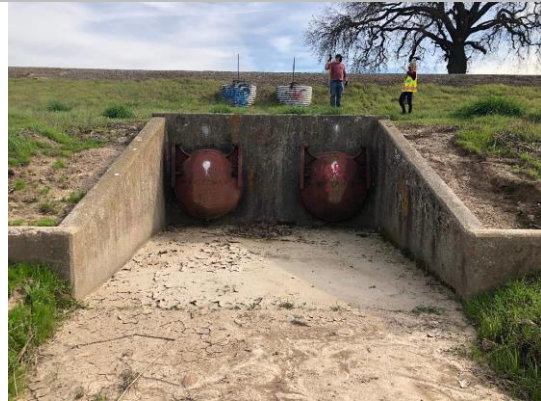
Photo 3 of 3 : UCIP_FA_2023_79001_93076.jpg

WS View: Headwall and 36-inch flapgate at WS toe.

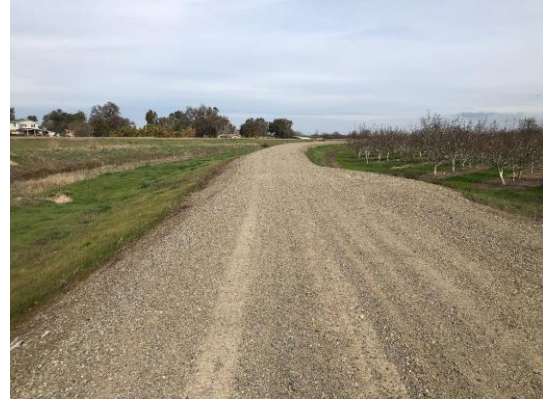
Photo 1 of 3 : UCIP_FA_2023_79002_93054.jpg

Comment Code						
Inspector Comment						
DS_ID:23745 FS_ID:79002 EP_NO: N/A Repair Type: Non-Urgent EVAL Issue: Crossing Status: Found UCIP Comments: 02/18/2021 Record was updated from No Action Needed to Non-Urgent. No permit was found authorizing this encroachment. CVFPB will need to review crossing to determine owner. DWR DMP has not found internal issues, LOF between 1 and 2. Recommend inspection in 5 years. The UCIP inspection was completed with DWR Inspector, S. Donovan, and LMA representative, J. Caruso. (N. Cholewinski - GEI) FIELD_STRUCT_DESC: 24-inch corrugated metal storm drainage pipe (CMP) through the levee, 7.0 feet below the crown. Flap gate on the waterside (WS) end. Concrete U-shaped headwalls on both ends. Cobble grouted outlet across the berm. Cobble grouted apron on the landside (LS) end. [Additional Reference(s): DWR Levee Log, 1990, (HLM 8.34). USACE San Joaquin O&M Manual 612.2, 1967, (HLM 8.34), and 612 (addendum), February 1999, (HLM 8.37), (Station 442+14), 24-inch pipe listed]. FS Date: 2/18/2021

Crown Overview

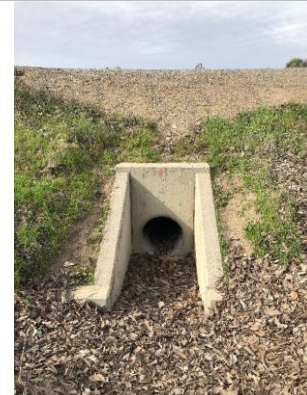
Photo 2 of 3 : UCIP_FA_2023_79002_93056.jpg

LS View: Headwall at LS toe.

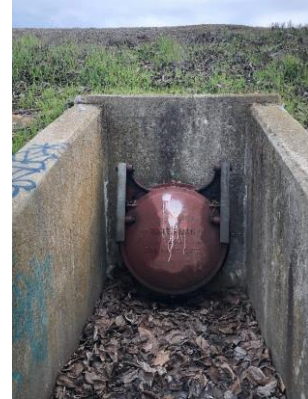
Photo 3 of 3 : UCIP_FA_2023_79002_93062.jpg

WS View: Headwall and 24-inch flapgate at WS slope.

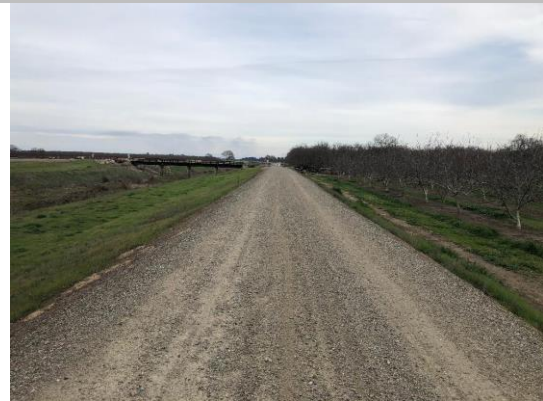
Photo 1 of 3 : UCIP_FA_2023_79003_93044.jpg

DS_ID:23746
 FS_ID:79003
 EP_NO: N/A
 Repair Type: Non-Urgent
 EVAL Issue:
 Crossing Status: Not Found
 UCIP Comments: 02/22/2021 Record was updated from No Action Needed to Non-Urgent. DWR DMP study found no evidence of pipe at lat/long 38.066918/-121.243749. Pipe not found by visual inspection. No permit was found authorizing this encroachment. CVFPB will need to review crossing to determine owner. The UCIP inspection was completed with DWR Inspector, S. Donovan, and LMA representative, J. Caruso. (N. Cholewinski - GEI)
 FIELD_STRUCT_DESC: 24-inch corrugated metal storm drainage pipe (CMP) through the levee, 7.0 feet below the crown. Flap gate on the waterside (WS) end. Concrete U-shaped headwalls on both ends. Cobble grouted outlet across the berm. Cobble grouted apron on the landside (LS) end. [Additional Reference(s): DWR Levee Log, 1990, (HLM 8.54). USACE San Joaquin O&M Manual 612.2, 1967, (HLM 8.54), and 612 (addendum), February 1999, (HLM 8.57), (Station 452+52), 24-inch pipe listed].

Crown Overview

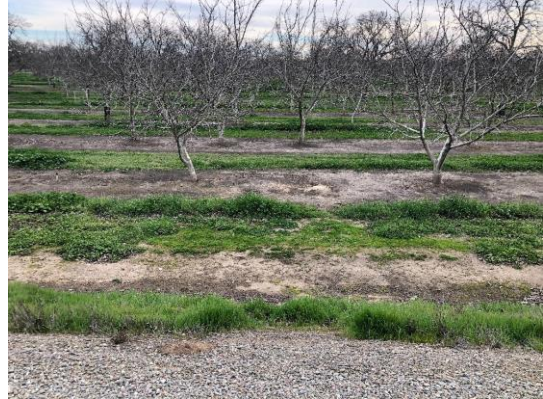
Photo 2 of 3 : UCIP_FA_2023_79003_93045.jpg

LS View

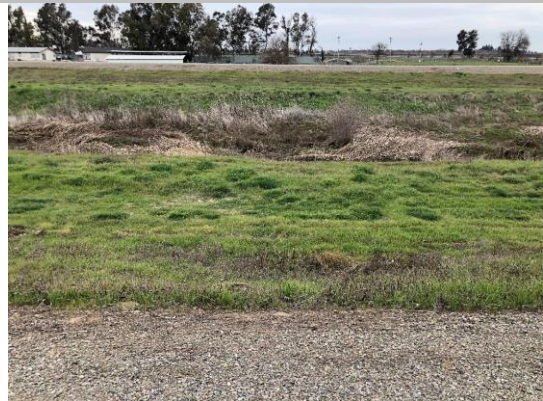
Photo 3 of 3 : UCIP_FA_2023_79003_93046.jpg

WS View

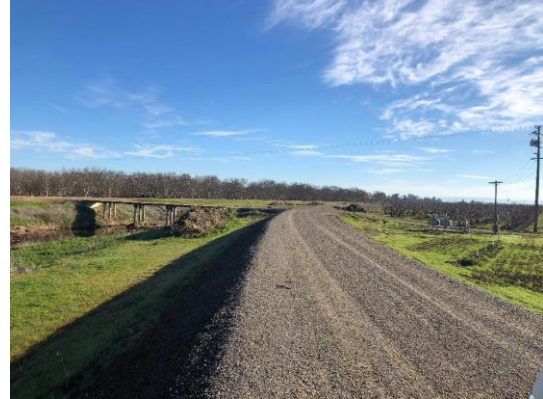
Photo 1 of 3 : UCIP_FA_2023_79004_93021.jpg

Comment Code						
Inspector Comment						
DS_ID:23722						
FS_ID:79004						
EP_NO: N/A						
Repair Type: Non-Urgent						
EVAL Issue:						
Crossing Status: Found						
UCIP Comments: 02/22/2021 Record was updated from No Action						
Needed to Non-Urgent. No permit was found authorizing this						
encroachment. CVFPB will need to review crossing to determine owner.						
DWR DMP has not found internal issues, LOF between 1 and 2.						
Recommend inspection in 5 years. The UCIP inspection was completed						
with DWR Inspector, S. Donovan, and LMA representative, J. Caruso.

Crown Overview

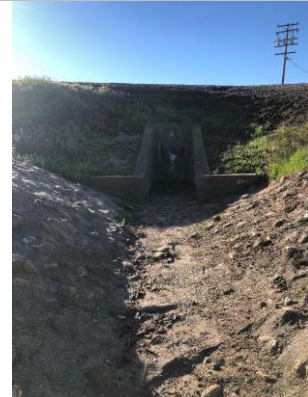
Photo 2 of 3 : UCIP_FA_2023_79004_93023.jpg

WS View: Headwall and flapgate at WS slope.

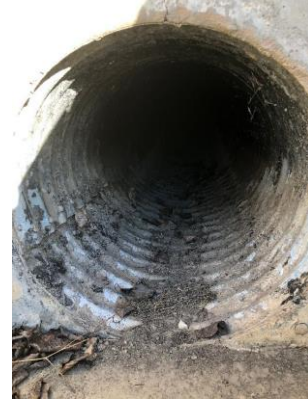
Photo 3 of 3 : UCIP_FA_2023_79004_93026.jpg

LS View: Pipe at LS toe.

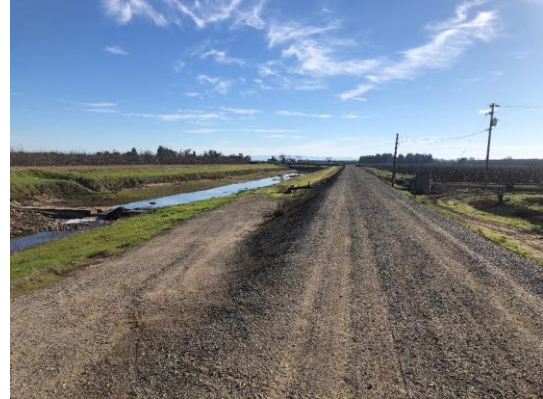
Photo 1 of 3 : UCIP_FA_2023_79039_92901.jpg

Comment Code						
Inspector Comment						
DS_ID:23726 FS_ID:79039 EP_NO: N/A Repair Type: No Action Needed EVAL Issue: Crossing Status: Found UCIP Comments: 09/18/2023 Record updated from Non-Urgent to No Action Needed. Pipe was CIPP lined. DMP internal video inspection has found none or minor pipe defects. Recommend next video inspection in 5 years. (O. Yakimov - DWR UCIP) 02/22/2021 Record was updated from No Action Needed to Non-Urgent. DWR DMP has found integrity issues, LOF between 4 and 5. Crossing will be monitored until funding becomes available for rehabilitation. No permit was found authorizing this encroachment. CVFPB will need to review crossing to determine owner. Approximately 7 bullet holes observed in WS flapgate. The UCIP inspection was completed with DWR Inspector, S. Donovan, and LMA representative, J. Caruso. (N. Cholewinski - GEI) FIELD_STRUCT_DESC: 24-inch CIPP-lined corrugated metal storm drainage pipe (CMP) through the levee, 8.5 feet below the crown. Flap gate on the waterside (WS) end. Concrete U-shaped headwalls on both ends. Cobble grouted outlet across the berm. Cobble grouted apron on the landside (LS) end. [Additional Reference(s): DWR Levee Log, 1990, (HLM 9.76). USACE San Joaquin O&M Manual 612.2, 1967, (HLM 9.85), and 612 (addendum), February 1999, (HLM 9.76), (Station 515+23), 24-inch pipe listed]. FS Date: 2/22/2021

Crown Overview

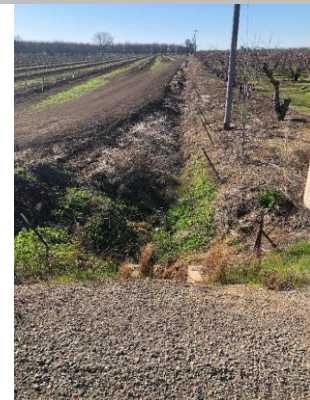
Photo 2 of 3 : UCIP_FA_2023_79039_92902.jpg

LS View: Headwall at LS toe.

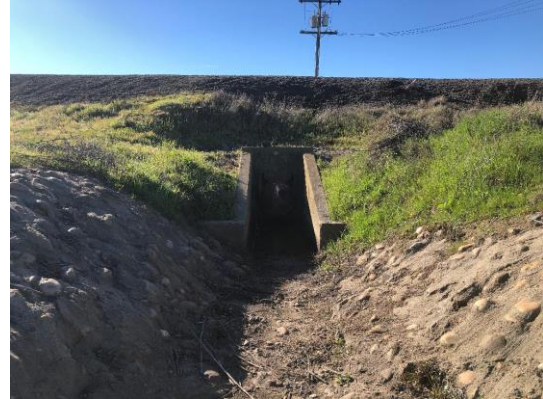
Photo 3 of 3 : UCIP_FA_2023_79039_92913.jpg

WS View: Headwall and flapgate at WS slope.

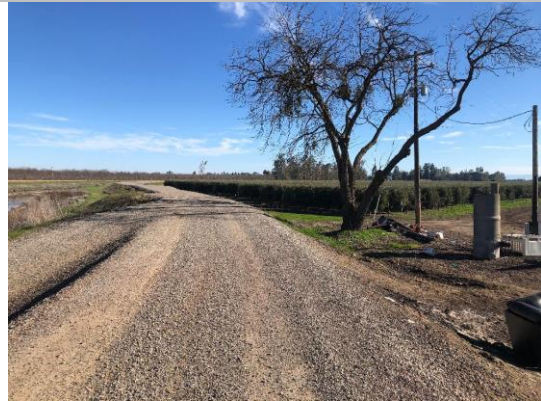
Photo 1 of 3 : UCIP_FA_2023_79006_92888.jpg

Crown Overview
