**Flood Control Project Maintenance
Levee Inspections**

Maintenance Issue Types Only, Levee Inspection Report By Mile - Fall 2023

San Joaquin County Flood Control and Water Conservation District

Waterway	Bank	Unit Miles	Inspection Start/End	Inspector
Unit No. 01 Littlejohn Creek	Left	2.59	10/20/2023 10/20/2023	Alberto De Leon

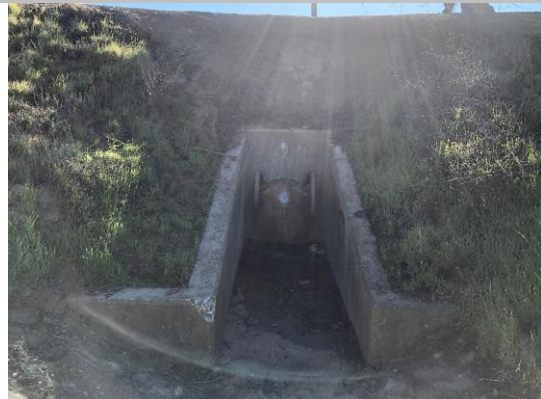
Photo 2 of 3 : UCIP_FA_2023_79006_92890.jpg

Comment Code						
Inspector Comment						
DS_ID:23727 FS_ID:79006 EP_NO: N/A Repair Type: Non-Urgent EVAL Issue: Crossing Status: Found UCIP Comments: 02/22/2021 Pipe status is still Non-Urgent. No permit was found authorizing this encroachment. CVFPB will need to review crossing to determine owner. DWR DMP has not found internal issues, LOF between 1 and 2. Recommend inspection in 5 years. Slope above WS headwall is very steep and eroding. Sediment from erosion observed on top of WS pipe outlet. Sediment build-up has decreased in pipe at LS toe. The UCIP inspection was completed with DWR Inspector, S. Donovan, and LMA representative, J. Caruso. (N. Cholewinski - GEI)05/21/2014 Sediment and debris buildup inside pipe on LS toe. (W. Wylie - DWR UCIP) FIELD_STRUCT_DESC: 24-inch corrugated metal storm drainage pipe (CMP) through the levee, 7.0 feet below the crown. Flap gate on the waterside (WS) end. Concrete U-shaped headwalls on both ends. Cobble grouted outlet across the berm. Cobble grouted apron on the landside (LS) end. [Additional Reference(s): DWR Levee Log, 1990, (HLM 10.01). USACE San Joaquin O&M Manual 612.2, 1967, (HLM 10.09), and 612 (addendum), February 1999, (HLM 10.00), (Station 528+18), 24-inch pipe listed]. FS Date: 2/22/2021

WS View: Headwall and flapgate on WS slope. Erosion observed above headwall.

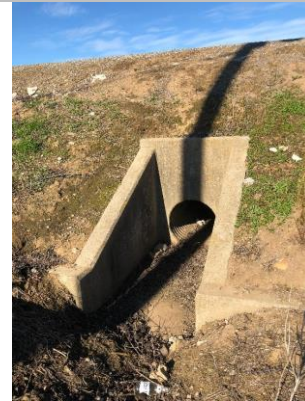
Photo 3 of 3 : UCIP_FA_2023_79006_92892.jpg

LS View: Headwall at LS toe.

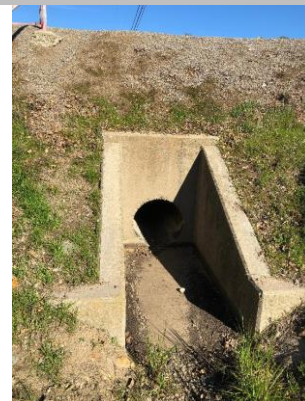
Photo 1 of 3 : UCIP_FA_2023_79007_92864.jpg

DS_ID:23728
 FS_ID:79007
 EP_NO: N/A
 Repair Type: Non-Urgent
 EVAL Issue:
 Crossing Status: Found
 UCIP Comments: 02/22/2021 Record was updated from No Action Needed to Non-Urgent. No permit was found authorizing this encroachment. CVFPB will need to review crossing to determine owner. DWR DMP has not found internal issues, LOF between 1 and 2. Recommend inspection in 5 years. Some concrete rubble observed above headwall on WS. The UCIP inspection was completed with DWR Inspector, S. Donovan, and LMA representative, J. Caruso. (N. Cholewinski - GEI)
 FIELD_STRUCT_DESC: 24-inch corrugated metal storm drainage pipe (CMP) through the levee, 9.0 feet below the crown. Flap gate on the waterside (WS) end. Concrete U-shaped headwalls on both ends. Cobble grouted outlet across the berm. Cobble grouted apron on the landside (LS) end. [Additional Reference(s): DWR Levee Log, 1990, (HLM 10.46). USACE San Joaquin O&M Manual 612.2, 1967, (HLM 10.46), and 612 (addendum), February 1999, (HLM 10.44), (Station 551+22), 24-inch pipe listed].

LS View: Facing headwall at LS toe.

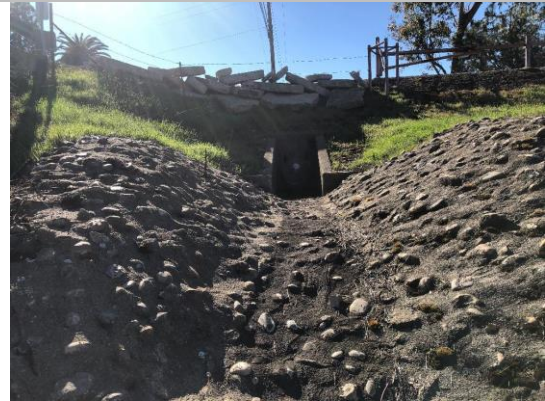
Photo 2 of 3 : UCIP_FA_2023_79007_92871.jpg

WS View: Headwall and flapgate at WS slope.

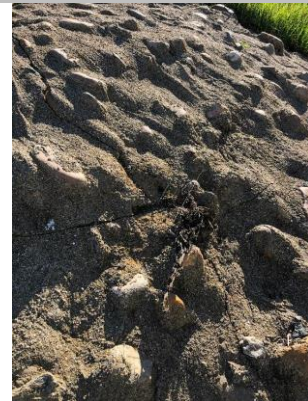
Photo 3 of 3 : UCIP_FA_2023_79007_92873.jpg

WS View: Small crack observed in apron on WS slope.

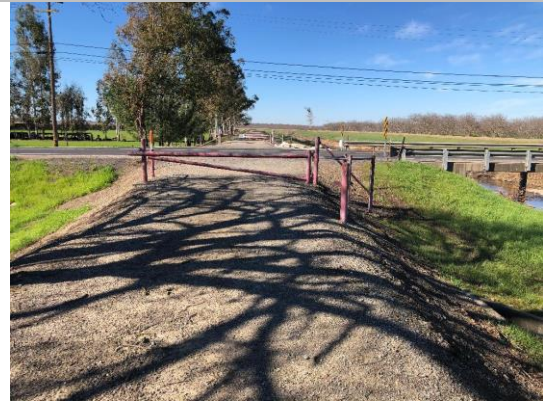
Photo 1 of 3 : UCIP_FA_2023_79008_92828.jpg

Comment Code						
Inspector Comment						
DS_ID:23729 FS_ID:79008 EP_NO: N/A Repair Type: Non-Urgent EVAL Issue: Crossing Status: Found UCIP Comments: 02/22/2021 Pipe status is still Non-Urgent. No permit was found authorizing this encroachment. CVFPB will need to review crossing to determine owner. DWR DMP has not found internal issues, LOF between 1 and 2. Recommend inspection in 5 years. Water observed at pipe opening at LS toe. The UCIP inspection was completed with DWR Inspector, S. Donovan, and LMA representative, J. Caruso. (N. Cholewinski - GEI)05/21/2014 Some sediment buildup in pipe at LS toe. (W. Wylie - DWR UCIP) FIELD_STRUCT_DESC: 24-inch corrugated metal storm drainage pipe (CMP) through the levee, 7.0 feet below the crown. Flap gate on the waterside (WS) end. Concrete U-shaped headwalls on both ends. Cobble grouted outlet across the berm. Cobble grouted apron on the landside (LS) end. [Additional Reference(s): DWR Levee Log, 1990, (HLM 10.48). USACE San Joaquin O&M Manual 612.2, 1967, (HLM 10.48), and 612 (addendum), February 1999, (HLM 10.46), (Station 552+17), 24-inch pipe listed]. FS Date: 2/22/2021

Crown Overview

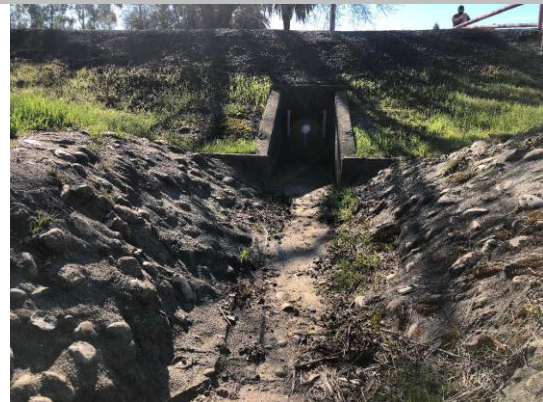
Photo 2 of 3 : UCIP_FA_2023_79008_92829.jpg

WS View: Headwall and flapgate at WS slope.

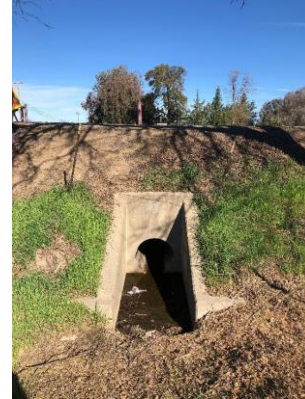
Photo 3 of 3 : UCIP_FA_2023_79008_92831.jpg

LS View: Headwall at LS toe.

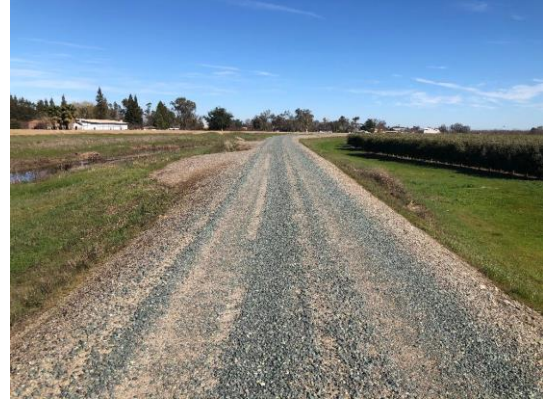
Photo 1 of 3 : UCIP_FA_2023_79009_92810.jpg

Comment Code					
Inspector Comment					
DS_ID:23748 FS_ID:79009 EP_NO: N/A Repair Type: Non-Urgent EVAL Issue: Crossing Status: Found UCIP Comments: 02/22/2021 Record was updated from No Action Needed to Non-Urgent. No permit was found authorizing this encroachment. CVFPB will need to review crossing to determine owner. DWR DMP has not found internal issues, LOF between 1 and 2. Recommend inspection in 5 years. 4.5-inch PVC pipe discharging at LS toe headwall. 2-inch PVC pipe on LS slope adjacent to headwall, seems disconnected. The UCIP inspection was completed with DWR Inspector, S. Donovan, and LMA representative, J. Caruso. (N. Cholewinski - GEI)05/21/2014 2-small PVC pipes discharge into inlet on LS toe. (W. Wylie - DWR UCIP) FIELD_STRUCT_DESC: 24-inch corrugated metal storm drainage pipe (CMP) through the levee, 7.0 feet below the crown. Flap gate on the waterside (WS) end. Concrete U-shaped headwalls on both ends. Cobble grouted outlet across the berm. Cobble grouted apron on the landside (LS) end. [Additional Reference(s): DWR Levee Log, 1990, (HLM 10.75). USACE San Joaquin O&M Manual 612.2, 1967, (HLM 10.75), and 612 (addendum), February 1999, (HLM 10.72), (Station 566+09), 24-inch pipe listed]. FS Date: 2/22/2021

Crown Overview

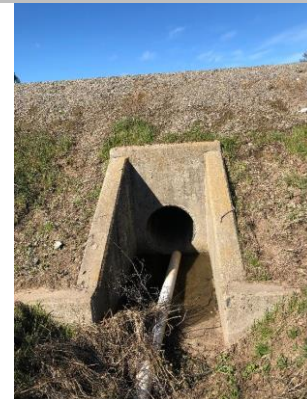
Photo 2 of 3 : UCIP_FA_2023_79009_92812.jpg

LS View: Headwall at LS toe. 4.5-inch PVC pipe discharges at headwall.

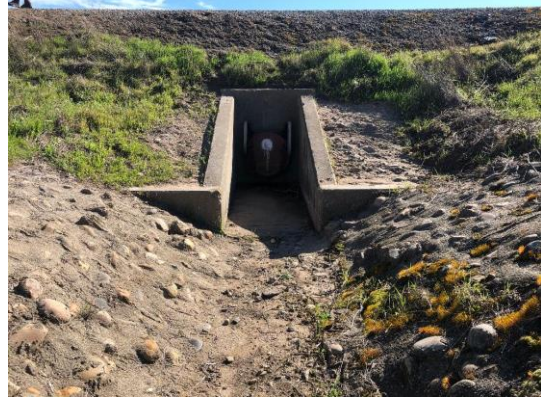
Photo 3 of 3 : UCIP_FA_2023_79009_92819.jpg

WS View: Headwall and flapgate at WS slope.

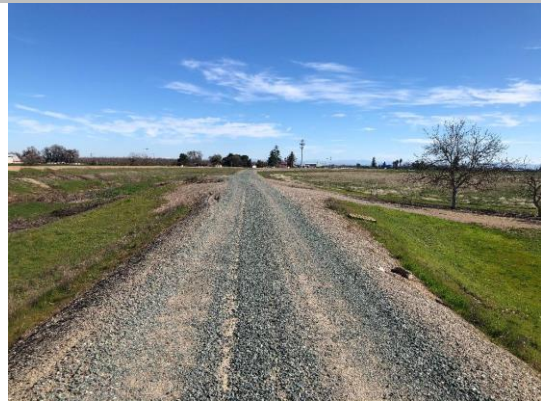
Photo 1 of 3 : UCIP_FA_2023_79010_92787.jpg

DS_ID:23749
 FS_ID:79010
 EP_NO: N/A
 Repair Type: Non-Urgent
 EVAL Issue:
 Crossing Status: Found
 UCIP Comments: 02/22/2021 Pipe status is still Non-Urgent. No permit was found authorizing this encroachment. CVFPB will need to review crossing to determine owner. DWR DMP has not found internal issues, LOF between 1 and 2. Recommend inspection in 5 years. The UCIP inspection was completed with DWR Inspector, S. Donovan, and LMA representative, J. Caruso. (N. Cholewinski - GEI)05/21/2014 Some silt buildup in pipe at LS toe. (W. Wylie - DWR UCIP)
 FIELD_STRUCT_DESC: 24-inch corrugated metal storm drainage pipe (CMP) through the levee, 8.0 feet below the crown. Flap gate on the waterside (WS) end. Concrete U-shaped headwalls on both ends. Cobble grouted outlet across the berm. Cobble grouted apron on the landside (LS) end. [Additional Reference(s): DWR Levee Log, 1990, (HLM 10.97). USACE San Joaquin O&M Manual 612.2, 1967, (HLM 10.97), and 612 (addendum), February 1999, (HLM 10.94), (Station 577+59), 24-inch pipe listed].

Crown Overview

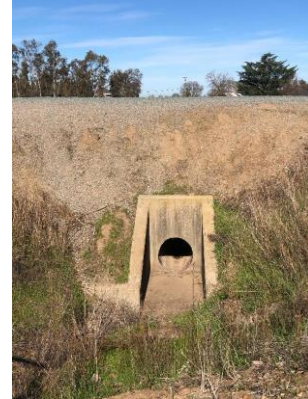
Photo 2 of 3 : UCIP_FA_2023_79010_92789.jpg

LS View: Headwall at LS toe.

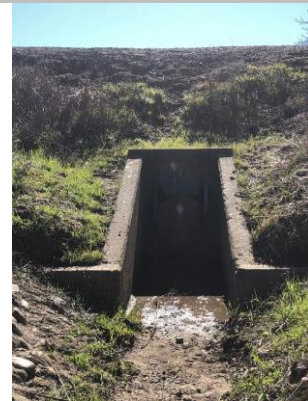
Photo 3 of 3 : UCIP_FA_2023_79010_92799.jpg

WS View: Headwall and flapgate at WS slope.

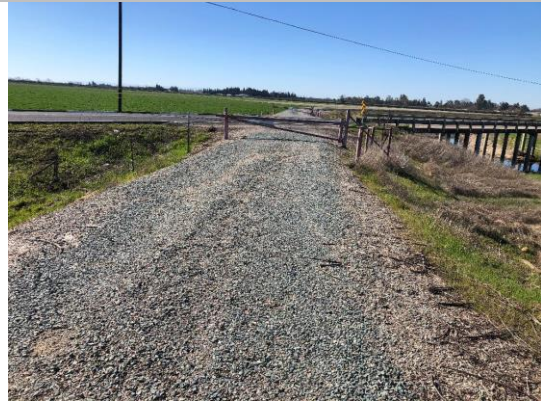
Photo 1 of 3 : UCIP_FA_2023_79011_92755.jpg

Comment Code					
Inspector Comment					
DS_ID:23750 FS_ID:79011 EP_NO: N/A Repair Type: Non-Urgent EVAL Issue: Crossing Status: Found UCIP Comments: 02/22/2021 Record was updated from No Action Needed to Non-Urgent. No permit was found authorizing this encroachment. CVFPB will need to review crossing to determine owner. DWR DMP has not completed an internal inspection of the pipe. The UCIP inspection was completed with DWR Inspector, S. Donovan, and LMA representative, J. Caruso. (N. Cholewinski - GEI) FIELD_STRUCT_DESC: 24-inch corrugated metal storm drainage pipe (CMP) through the levee, 7.0 feet below the crown. Flap gate on the waterside (WS) end. Concrete U-shaped headwalls on both ends. Cobble grouted outlet across the berm. Cobble grouted apron on the landside (LS) end. [Additional Reference(s): DWR Levee Log, 1990, (HLM 11.32). USACE San Joaquin O&M Manual 612.2, 1967, (HLM 11.32), and 612 (addendum), February 1999, (HLM 11.28), (Station 595+39), 24-inch pipe listed]. FS Date: 2/22/2021

Crown Overview

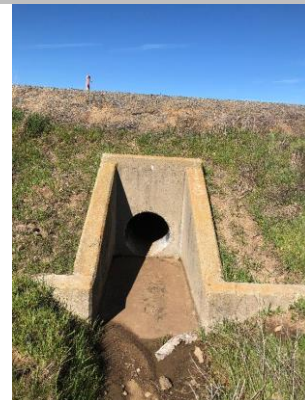
Photo 2 of 3 : UCIP_FA_2023_79011_92764.jpg

LS View: Headwall at LS toe.

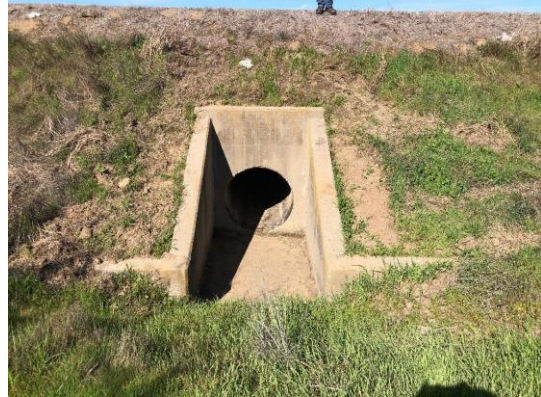
Photo 2 of 3 : UCIP_FA_2023_79012_92744.jpg

LS View: Headwall at LS toe.

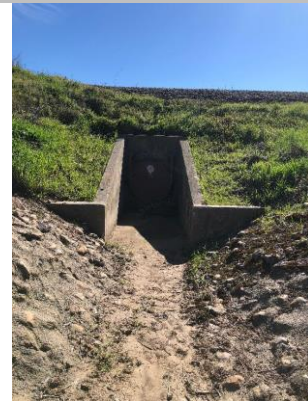
Photo 3 of 3 : UCIP_FA_2023_79012_92748.jpg

WS View: Headwall and flapgate at WS slope.

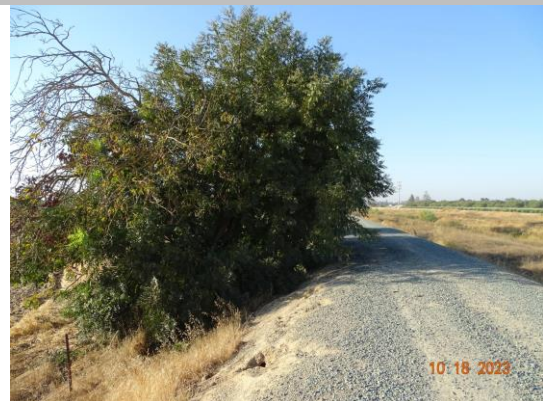
Photo 1 of 1 : FA_2023_NA0017_152_89_20231101_00250.jpg

LM Start	11.20	Rating **	U	Issue No.	89
LM End	11.20	Issue Type +	Ma	Location *	LS
Category	Earthen Levee			GPS Latitude/Longitude	
				Start	End
Item	Trim / Thin Trees			38.082364°	38.082364°
				-121.197967°	-121.197967°
DWR ID	DWR_NA0017_08_f_2023_89				
Comment Code					
T1 : Trim and thin trees to at least five feet above ground level to allow visibility of the ground and room to flood fight.					
Inspector Comment

View of untrimmed tree along the landside slope. Fall 2023

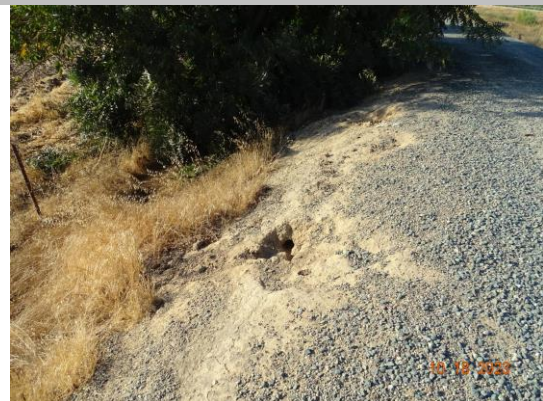
Photo 1 of 1 : FA_2023_NA0017_152_85_20231101_00251.jpg

LM Start	11.20	Rating **	U	Issue No.	85
LM End	11.20	Issue Type +	Ma	Location *	LS
Category	Earthen Levee			GPS Latitude/Longitude	
				Start	End
Item	Animal Control			38.082315°	38.082315°
				-121.197898°	-121.197898°
DWR ID	DWR_NA0017_08_s_2023_85				
Comment Code					
A1 : Exterminate rodents and backfill and compact or grout burrows.					
Inspector Comment

View of animal burrows along the landside slope. Fall 2023

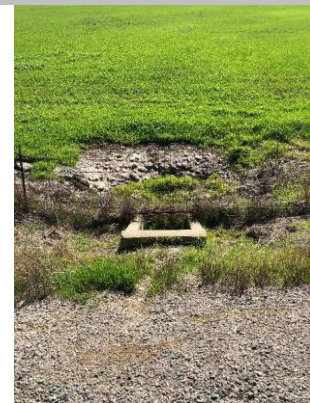
Photo 1 of 3 : UCIP_FA_2023_79013_92695.jpg

Comment Code						
Inspector Comment						
DS_ID:23752 FS_ID:79013 EP_NO: N/A Repair Type: Non-Urgent EVAL Issue: Crossing Status: Found UCIP Comments: 02/22/2021 Record was updated from No Action Needed to Non-Urgent. No permit was found authorizing this encroachment. CVFPB will need to review crossing to determine owner. DWR DMP has not found internal issues, LOF between 1 and 2. Recommend inspection in 5 years. The UCIP inspection was completed with DWR Inspector, S. Donovan, and LMA representative, J. Caruso. (N. Cholewinski - GEI) FIELD_STRUCT_DESC: 24-inch corrugated metal storm drainage pipe (CMP) through the levee, 9.5 feet below the crown. Flap gate on the waterside (WS) end. Concrete U-shaped headwalls on both ends. Cobble grouted outlet across the berm. Cobble grouted apron on the landside (LS) end. [Additional Reference(s): DWR Levee Log, 1990, (HLM 11.59). USACE San Joaquin O&M Manual 612.2, 1967, (HLM 11.59), and 612 (addendum), February 1999, (HLM 11.60), (Station 612+48), 24-inch pipe listed]. FS Date: 2/22/2021

LS View: Headwall at LS toe.

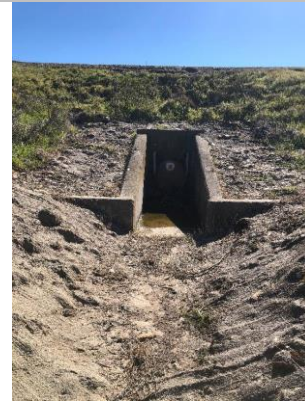
Photo 2 of 3 : UCIP_FA_2023_79013_92699.jpg

WS View: Headwall and flapgate at WS slope.

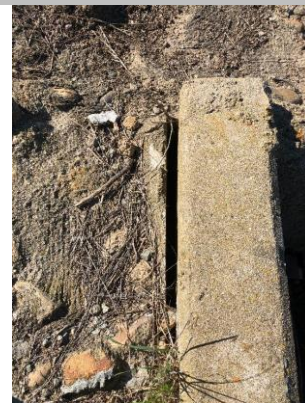
Photo 3 of 3 : UCIP_FA_2023_79013_92700.jpg

WS View: 1.5-inch gap observed between headwall and apron at WS slope.

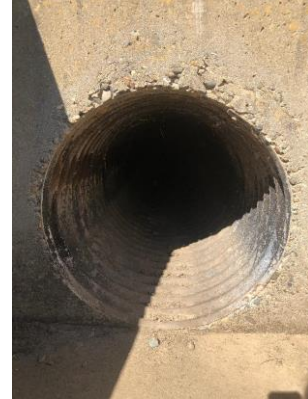
Photo 2 of 3 : UCIP_FA_2023_79014_92690.jpg

LS View: Pipe at LS toe.

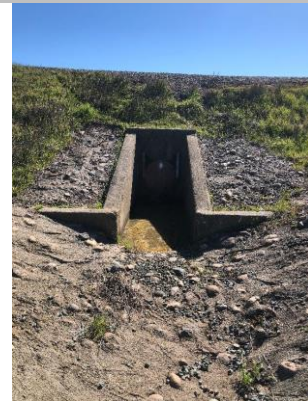
Photo 3 of 3 : UCIP_FA_2023_79014_92692.jpg

WS View: Headwall and flapgate at WS slope.

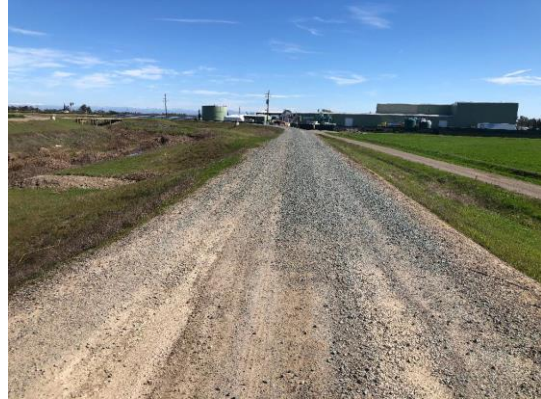
Photo 1 of 3 : UCIP_FA_2023_79015_92681.jpg

Comment Code						
Inspector Comment						
DS_ID:23754 FS_ID:79015 EP_NO: N/A Repair Type: Non-Urgent EVAL Issue: Crossing Status: Found UCIP Comments: 02/22/2021 Record was updated from No Action Needed to Non-Urgent. No permit was found authorizing this encroachment. CVFPB will need to review crossing to determine owner. DWR DMP has not found internal issues, LOF between 1 and 2. Recommend inspection in 5 years. A 4.5-inch PVC pipe is positioned to discharge at the LS inlet. The 4.5-inch PVC pipe is an unauthorized engroachment that has been installed along the LS toe. Recommend having the CVFPB review this record to have landowner remove the illegal encroachment along the LS toe. The UCIP inspection was completed with DWR Inspector, S. Donovan, and LMA representative, J. Caruso. (N. Cholewinski - GEI)04/26/2017 Rodent activity is already accounted for via DWR FPIIB inspections. As per inspection chief G. Wylie, crossing has been downgraded from Non-Urgent to No Action Needed, as pipe integrity itself is not in question. (K. Fazel - UCIP)05/21/2014 Rodent activity at LS shoulder. (G. Wylie - FPIIB) FIELD_STRUCT_DESC: 24-inch corrugated metal storm drainage pipe (CMP) through the levee, 7.5 feet below the crown. Flap gate on the waterside (WS) end. Concrete U-shaped headwalls on both ends. Cobble grouted outlet across the berm. Cobble grouted apron on the landside (LS) end. [Additional Reference(s): DWR Levee Log, 1990, (HLM 12.06). USACE San Joaquin O&M Manual 612.2, 1967, (HLM 12.06), 24-inch pipe listed]. FS Date: 2/22/2021

Crown Overview

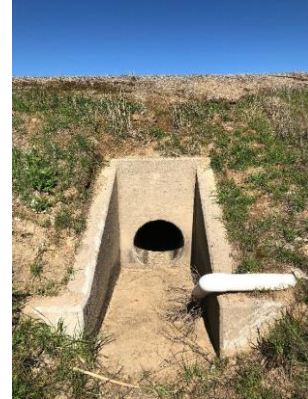
Photo 2 of 3 : UCIP_FA_2023_79015_92683.jpg

LS View: Headwall at LS toe. PVC pipe discharging at inlet.

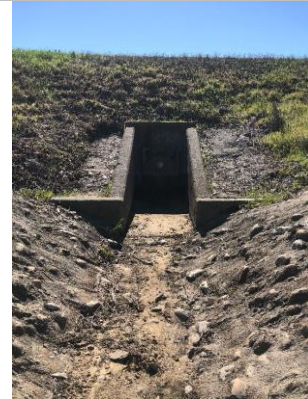
Photo 3 of 3 : UCIP_FA_2023_79015_92685.jpg

WS View: Headwall and flapgate at WS slope.

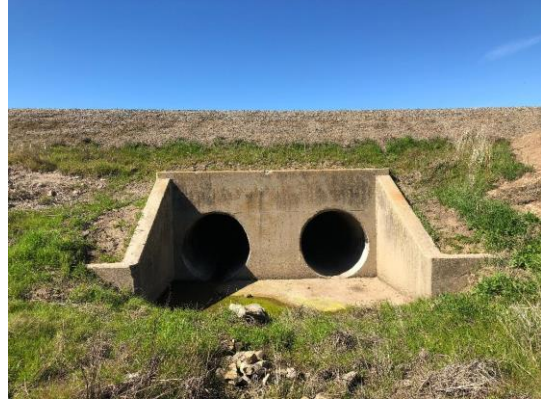
Photo 1 of 3 : UCIP_FA_2023_79016_92663.jpg

Comment Code					
Inspector Comment					
DS_ID:23756 FS_ID:79016 EP_NO: N/A Repair Type: Non-Urgent EVAL Issue: 4b, Safety Issue Crossing Status: Found UCIP Comments: 02/22/2021 Pipe status is still Non-Urgent. No permit was found authorizing this encroachment. CVFPB will need to review crossing to determine owner. DWR DMP has not found internal issues, LOF between 1 and 2. Recommend inspection in 5 years. Riser lid damage. Recommend adding lid to riser as a safety measure. The UCIP inspection was completed with DWR Inspector, S. Donovan, and LMA representative, J. Caruso. (N. Cholewinski - GEI)05/21/2014 CMP riser missing cover on WS slope. (W. Wylie - DWR UCIP) FIELD_STRUCT_DESC: 1 of 2: 48-inch corrugated metal storm drainage pipe (CMP) through the levee, 8.5 feet below the crown. Slide gate inside a 60-inch CMP riser unit on the waterside (WS) slope. Concrete U-shaped headwalls on both ends. Cobble grouted outlet on the WS end. Cobble grouted apron on the landside (LS) end. [Additional Reference(s): DWR Levee Log, 1990, (HLM 12.20). USACE San Joaquin O&M Manual 612.2, 1967, (HLM 12.20), and 612 (addendum), February 1999, (HLM 12.13), (Station 640+50), 48-inch pipe listed]. FS Date: 2/22/2021

LS View: Headwall at LS toe.

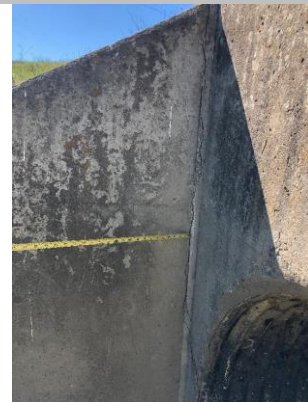
Photo 2 of 3 : UCIP_FA_2023_79016_92664.jpg

LS View: Surficial crack observed at headwall bend leading to pipe.

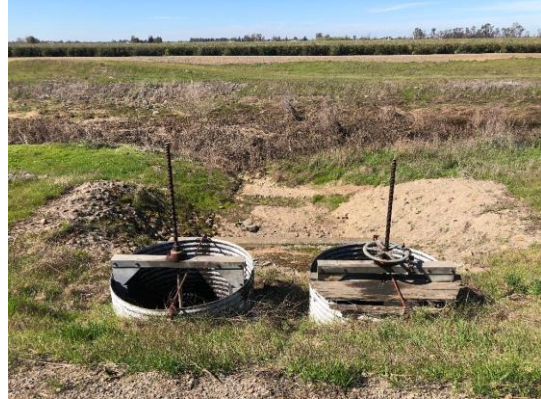
Photo 3 of 3 : UCIP_FA_2023_79016_92667.jpg

WS View: Riser at WS shoulder.

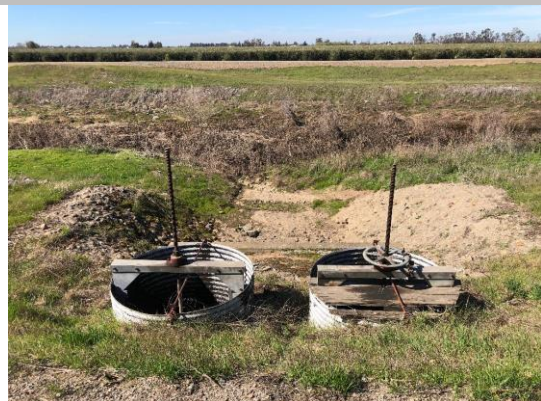
Photo 1 of 3 : UCIP_FA_2023_79017_92656.jpg

DS_ID:23818
 FS_ID:79017
 EP_NO: N/A
 Repair Type: Non-Urgent
 EVAL Issue: 4b, Safety Issue
 Crossing Status: Found
 UCIP Comments: 02/22/2021 Pipe status is still Non-Urgent. No permit was found authorizing this encroachment. CVFPB will need to review crossing to determine owner. DWR DMP has not found internal issues, LOF between 1 and 2. Recommend inspection in 5 years. Riser lid missing. Recommend adding riser lid for safety reasons. The UCIP inspection was completed with DWR Inspector, S. Donovan, and LMA representative, J. Caruso. (N. Cholewinski - GEI)05/21/2014 CMP riser missing cover on WS slope may be hazard. (W. Wylie - DWR UCIP)
 FIELD_STRUCT_DESC: 2 of 2: 48-inch corrugated metal storm drainage pipe (CMP) through the levee, 8.5 feet below the crown. Slide gate inside a 60-inch CMP riser unit on the waterside (WS) slope. Concrete U-shaped headwalls on both ends. Cobble grouted outlet on the WS end. Cobble grouted apron on the landside (LS) end. [Additional Reference(s): DWR Levee Log, 1990, (HLM 12.20). USACE San Joaquin O&M Manual 612.2, 1967, (HLM 12.20), and 612 (addendum), February 1999, (HLM 12.13), (Station 640+50), 48-inch pipe listed].

WS View: Riser at WS Shoulder. Partly covered with wood boards.
 Headwall and flapgate at WS toe.

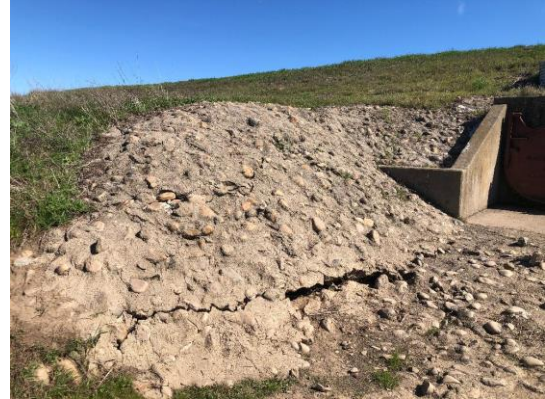
Photo 2 of 3 : UCIP_FA_2023_79017_92658.jpg

WS View: Crack observed in apron at WS toe.

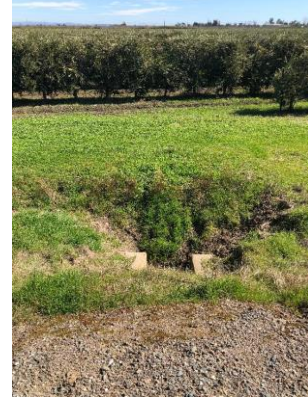
Photo 1 of 3 : UCIP_FA_2023_79018_92645.jpg

Comment Code					
Inspector Comment					
DS_ID:23757 FS_ID:79018 EP_NO: N/A Repair Type: Non-Urgent EVAL Issue: Crossing Status: Found UCIP Comments: 02/22/2021 Pipe status is still Non-Urgent. No permit was found authorizing this encroachment. CVFPB will need to review crossing to determine owner. DWR DMP has not found internal issues, LOF between 1 and 2. Recommend inspection in 5 years. The UCIP inspection was completed with DWR Inspector, S. Donovan, and LMA representative, J. Caruso. (N. Cholewinski – GEI)05/21/2014 Some sediment buildup in pipe at inlet. (W. Wylie - DWR DMP) FIELD_STRUCT_DESC: 24-inch corrugated metal storm drainage pipe (CMP) through the levee, 9.0 feet below the crown. Flap gate on the waterside (WS) end. Concrete U-shaped headwalls on both ends. Cobble grouted outlet across the berm. Cobble grouted apron on the landside (LS) end. [Additional Reference(s): DWR Levee Log, 1990, (HLM 12.43). USACE San Joaquin O&M Manual 612.2, 1967, (HLM 12.43), and 612 (addendum), February 1999, (HLM 12.36), (Station 652+74), 24-inch pipe listed]. FS Date: 2/22/2021

LS View: Headwall at LS toe.

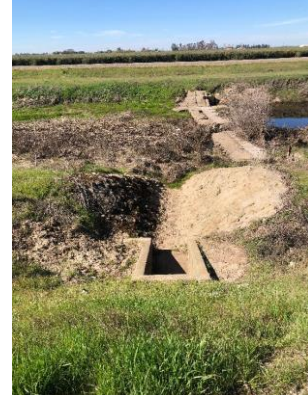
Photo 2 of 3 : UCIP_FA_2023_79018_92647.jpg

WS View: Headwall and flapgate at WS slope.

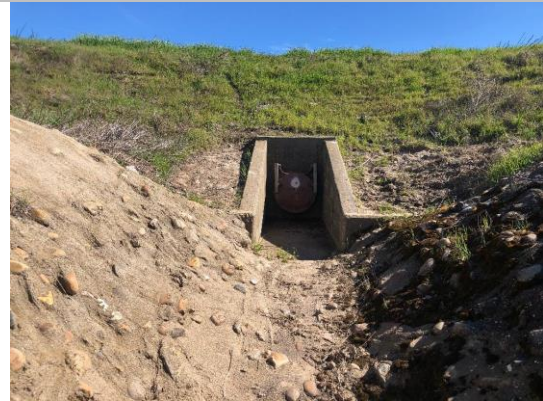
Photo 3 of 3 : UCIP_FA_2023_79018_92648.jpg

WS View: Headwall and flapgate at WS slope.

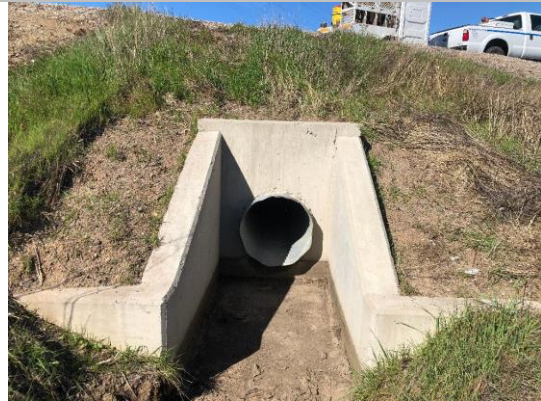
Photo 1 of 3 : UCIP_FA_2023_79019_92629.jpg

Comment Code						
Inspector Comment						
DS_ID:23761 FS_ID:79019 EP_NO: N/A Repair Type: Urgent EVAL Issue: 1, Pipe Integrity Crossing Status: Found UCIP Comments: 02/22/2021 Record was updated from No Action Needed to Urgent. DWR DMP has found integrity issues, LOF between 5 and 6. Crossing will be monitored until funding becomes available for removal. No permit was found authorizing this encroachment. There appears to be a gap between the headwall and concrete apron. Recommend monitoring the gap to determine if it is associated with undermining occurring. CVFPB will need to review crossing to determine owner. The UCIP inspection was completed with LMA representative, J. Caruso. (N. Cholewinski - GEI) FIELD_STRUCT_DESC: 24-inch corrugated metal storm drainage pipe (CMP) through the levee, 7.5 feet below the crown. Flap gate on the waterside (WS) end. Concrete U-shaped headwalls on both ends. Cobble grouted outlet across the berm. Cobble grouted apron on the landside (LS) end. [Additional Reference(s): DWR Levee Log, 1990, (HLM 12.78). USACE San Joaquin O&M Manual 612.2, 1967, (HLM 12.78), and 612 (addendum), February 1999, (HLM 12.70), (Station 670+43), 24-inch pipe listed]. FS Date: 2/22/2021

LS View: Headwall at LS toe.

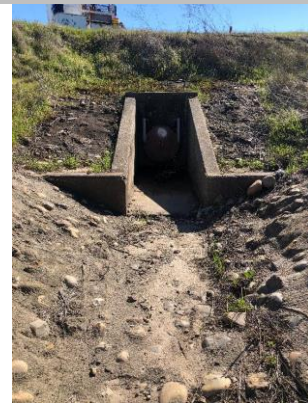
Photo 2 of 3 : UCIP_FA_2023_79019_92633.jpg

WS View: Headwall and flapgate at WS slope.

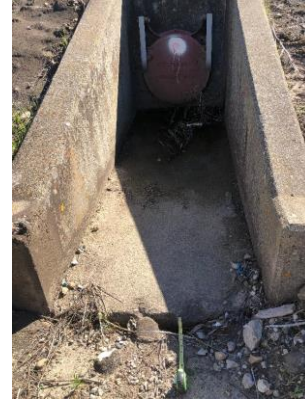
Photo 3 of 3 : UCIP_FA_2023_79019_92634.jpg

WS View: Headwall and flapgate at WS slope. Gap visible between headwall and apron.

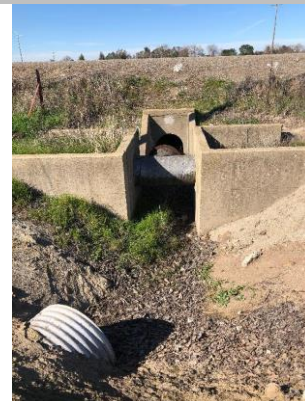
Photo 1 of 3 : UCIP_FA_2023_79020_92608.jpg

DS_ID:23764
 FS_ID:79020
 EP_NO: N/A
 Repair Type: Non-Urgent
 EVAL Issue:
 Crossing Status: Found
 UCIP Comments: 02/22/2021 Record was updated from No Action Needed to Non-Urgent. No permit was found authorizing this encroachment. CVFPB will need to review crossing to determine owner. DWR DMP has not found internal issues, LOF between 1 and 2. Recommend inspection in 5 years. The UCIP inspection was completed with LMA representative, J. Caruso. (N. Cholewinski – GEI)
 FIELD_STRUCT_DESC: 36-inch corrugated metal storm drainage pipe (CMP) through the levee, 9.0 feet below the crown. Flap gate on the waterside (WS) end. Concrete U-shaped headwalls on both ends. Cobble grouted outlet on the WS end. Cobble grouted apron on the landside (LS) end. [Additional Reference(s): DWR Levee Log, 1990, (HLM 12.94). USACE San Joaquin O&M Manual 612.2, 1967, (HLM 12.94), and 612 (addendum), February 1999, (HLM 12.86), (Station 678+88), 36-inch pipe listed].

LS View: Abandoned irrigation structure at LS toe.

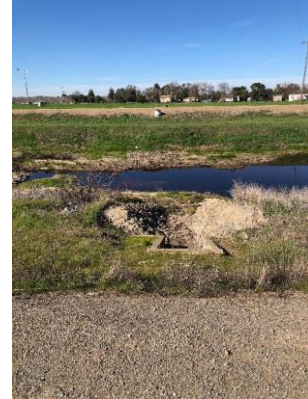
Photo 2 of 3 : UCIP_FA_2023_79020_92611.jpg

WS View: Headwall and flapgate at WS slope.

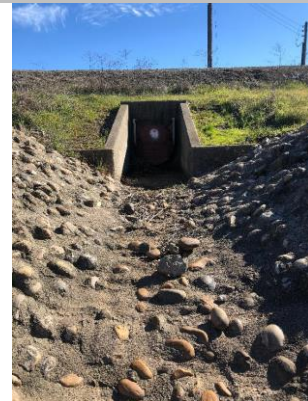
Photo 3 of 3 : UCIP_FA_2023_79020_92612.jpg

WS View: Headwall and flapgate at WS slope.

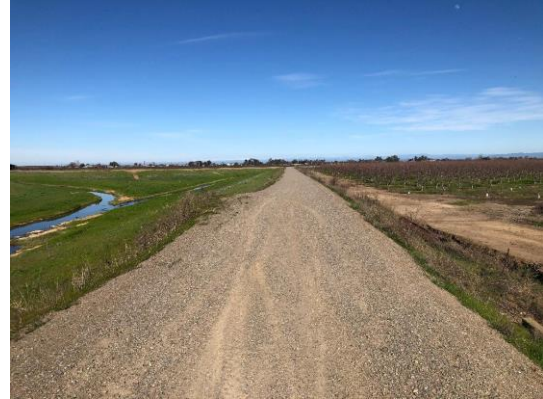
Photo 1 of 3 : UCIP_FA_2023_79021_92597.jpg

Comment Code						
Inspector Comment						
DS_ID:23765 FS_ID:79021 EP_NO: N/A Repair Type: No Action Needed EVAL Issue: Crossing Status: Found UCIP Comments: 09/18/2023 Record updated from Non-Urgent to No Action Needed. Pipe was CIPP lined. DMP internal video inspection has found none or minor pipe defects. Recommend next video inspection in 5 years. (O. Yakimov - DWR UCIP) 02/22/2021 Record was updated from No Action Needed to Non-Urgent. DWR DMP has found integrity issues, LOF between 4 and 5. Crossing will be monitored until funding becomes available for rehabilitation. No permit was found authorizing this encroachment. CVFPB will need to review crossing to determine owner. The UCIP inspection was completed with LMA representative, J. Caruso. (N. Cholewinski - GEI) FIELD_STRUCT_DESC: 24-inch CIPP-lined corrugated metal storm drainage pipe (CMP) through the levee, 9.0 feet below the crown. Flap gate on the waterside (WS) end. Slide gate on the landside (LS) end. Concrete U-shaped headwalls on both ends. Cobble grouted outlet across the berm. Cobble grouted apron on the LS end. [Additional Reference(s): DWR Levee Log, 1990, (HLM 13.00). USACE San Joaquin O&M Manual 612.2, 1967, (HLM 13.00), 24-inch pipe listed]. FS Date: 2/22/2021

Crown Overview

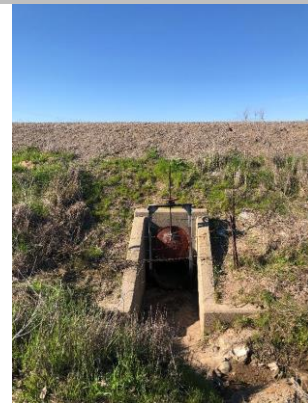
Photo 2 of 3 : UCIP_FA_2023_79021_92600.jpg

LS View: Headwall and slide gate at LS toe.

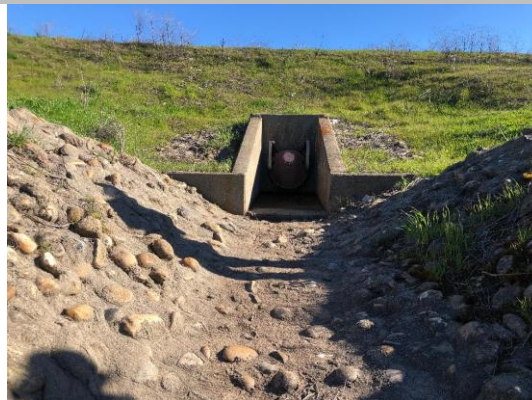
Photo 3 of 3 : UCIP_FA_2023_79021_92602.jpg

WS View: Headwall and flapgate at WS toe.

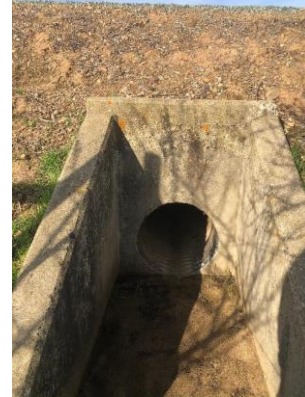
Photo 1 of 2 : UCIP_FA_2023_79022_92583.jpg

Comment Code						
Inspector Comment						
DS_ID:23767						
FS_ID:79022						
EP_NO: N/A						
Repair Type: Non-Urgent						
EVAL Issue:						
Crossing Status: Found						
UCIP Comments: 02/23/2021 Record was updated from No Action						
Needed to Non-Urgent. No permit was found authorizing this						
encroachment. CVFPB will need to review crossing to determine owner.						
DWR DMP has not found internal issues, LOF between 1 and 2.						
Recommend inspection in 5 years. The UCIP inspection was completed						
with LMA representative, J. Caruso. (N. Cholewinski – GEI)						
FIELD_STRUCT_DESC: 24-inch corrugated metal storm drainage pipe						
(CMP) through the levee, 7.0 feet below the crown. Flap gate on the						
waterside (WS) end. Concrete U-shaped headwalls on both ends.						
Cobble grouted outlet on the WS end. Cobble grouted intake on the						
landside (LS). [Additional Reference(s): DWR Levee Log, 1990, (HLM

LS View: Headwall at LS toe.

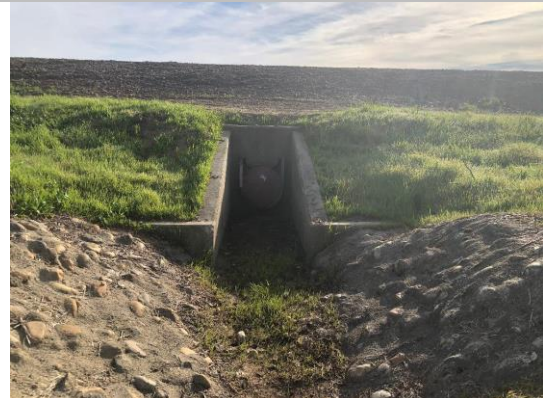
Photo 2 of 2 : UCIP_FA_2023_79022_92586.jpg

WS View: Headwall and flapgate at WS slope.

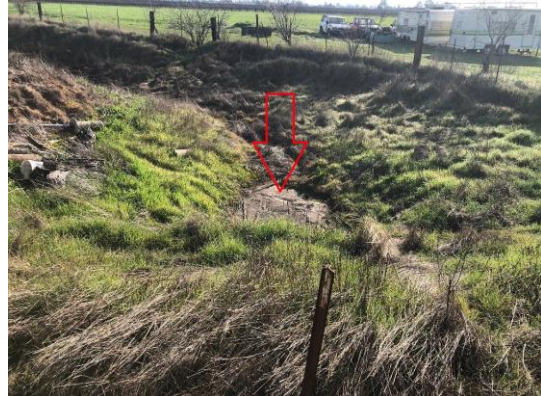
Photo 1 of 3 : UCIP_FA_2023_78501_92575.jpg

Comment Code						
Inspector Comment						
DS_ID:23768						
FS_ID:78501						
EP_NO: N/A						
Repair Type: Non-Urgent						
EVAL Issue: 4b, Safety Issue						
Crossing Status: Found						
UCIP Comments: 02/23/2021 Pipe status is still Non-Urgent. No permit was found authorizing this encroachment. CVFPB will need to review crossing to determine owner. DWR DMP has not found internal issues, LOF between 1 and 2. Recommend inspection in 5 years. LS not accessible due to barbed cattle fencing. Riser lid missing. Recommend adding lid to riser as a safety measure. The UCIP inspection was completed with LMA representative, J. Caruso. (N. Cholewinski – GEI)05/21/2014 Some debris buildup at inlet. No lid on CMP riser on WS slope. (W. Wylie - DWR DMP)						
FIELD_STRUCT_DESC: 1 of 2: 36-inch corrugated metal storm drainage pipe (CMP) through the levee, 10.0 feet below the crown. Concrete U-shaped headwalls on both ends. Slide gate inside a CMP riser unit on the waterside (WS) slope. Flap gate on the WS end. [Additional Reference(s): DWR Levee Log, 1990, (HLM 13.35). USACE San Joaquin O&M Manual 612.2, 1967, (HLM 13.35), 36-inch pipe listed].

LS View: Pipe at LS toe with cattle fencing around opening.

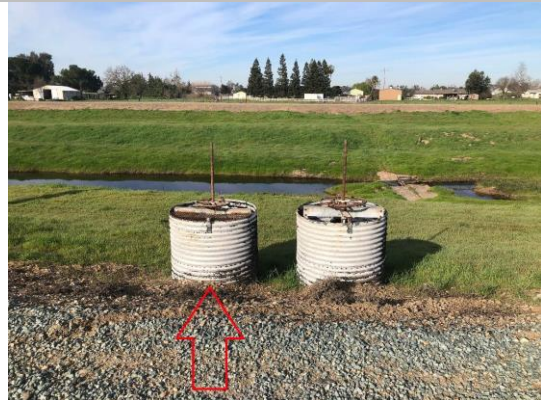
Photo 2 of 3 : UCIP_FA_2023_78501_92580.jpg

WS View: Riser on WS shoulder.

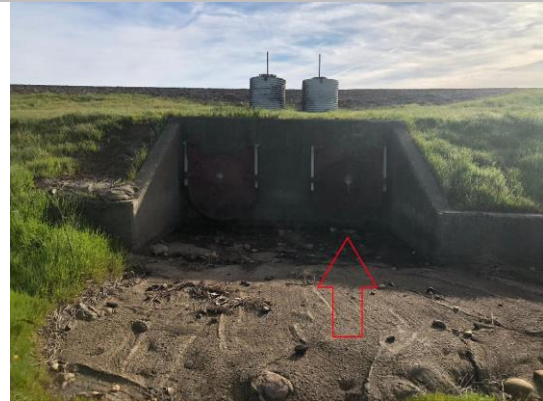
Photo 3 of 3 : UCIP_FA_2023_78501_92579.jpg

WS View: Headwall and flapgate at WS toe.

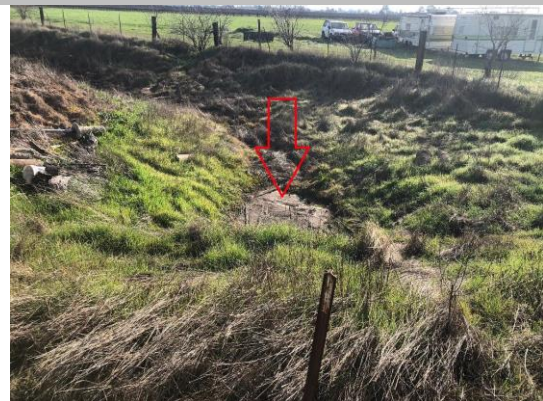
Photo 1 of 3 : UCIP_FA_2023_78502_92569.jpg

DS_ID:23816
 FS_ID:78502
 EP_NO: N/A
 Repair Type: Non-Urgent
 EVAL Issue: 4b, Safety Issue
 Crossing Status: Found
 UCIP Comments: 02/23/2021 Pipe status is still Non-Urgent. No permit was found authorizing this encroachment. CVFPB will need to review crossing to determine owner. DWR DMP has not found internal issues, LOF between 1 and 2. Recommend inspection in 5 years. LS not accessible due to barbed cattle fencing. Riser lid missing. Recommend adding lid to riser as a safety measure. The UCIP inspection was completed with LMA representative, J. Caruso. (N. Cholewinski – GEI)05/21/2014 Some debris buildup at inlet and no lid on standpipe at WS shoulder. (W. Wylie - DWR DMP)
 FIELD_STRUCT_DESC: 2 of 2: 36-inch corrugated metal storm drainage pipe (CMP) through the levee, 10.0 feet below the crown. Concrete U-shaped headwalls on both ends. Slide gate inside a CMP riser unit on the waterside (WS) slope. Flap gate on the WS end.

LS View: Cattle fencing around inlet at LS toe.

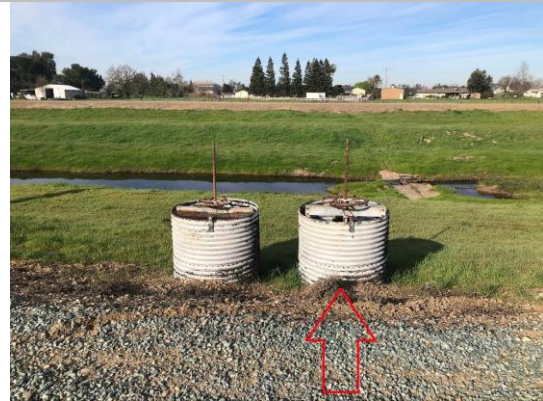
Photo 2 of 3 : UCIP_FA_2023_78502_92570.jpg

WS View: Riser on WS shoulder.

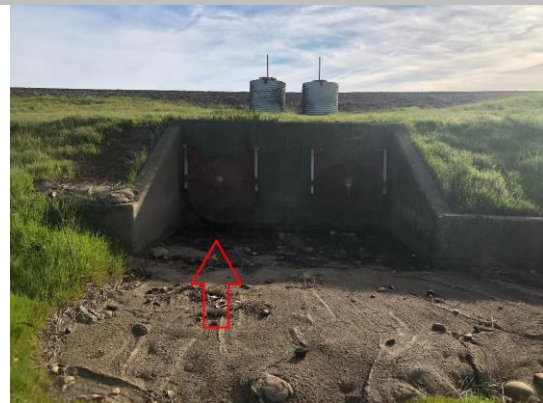
Photo 3 of 3 : UCIP_FA_2023_78502_92572.jpg

WS View: Headwall and flapgate at WS toe.

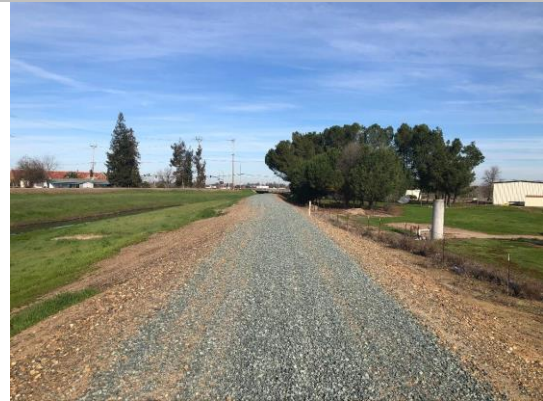
Photo 1 of 3 : UCIP_FA_2023_79023_92560.jpg

Comment Code						
Inspector Comment						
DS_ID:23769 FS_ID:79023 EP_NO: N/A Repair Type: Non-Urgent EVAL Issue: Crossing Status: Found UCIP Comments: 02/23/2021 Record was updated from No Action Needed to Non-Urgent. No permit was found authorizing this encroachment. CVFPB will need to review crossing to determine owner. DWR DMP has not found internal issues, LOF between 1 and 2. Recommend inspection in 5 years. Standpipe, 24-inch OD, located landward of LS toe is discharging at storm drain inlet at LS toe. The UCIP inspection was completed with LMA representative, J. Caruso. (N. Cholewinski – GEI) FIELD_STRUCT_DESC: 24-inch corrugated metal storm drainage pipe (CMP) through the levee, 8.0 feet below the crown. Flap gate on the waterside (WS) end. Concrete U-shaped headwalls on both ends. Cobble grouted outlet on the WS end. Cobble grouted intake on the landside (LS). [Additional Reference(s): DWR Levee Log, 1990, (HLM 13.50). USACE San Joaquin O&M Manual 612.2, 1967, (HLM 13.50), 24-inch pipe listed]. FS Date: 2/23/2021

Crown Overview

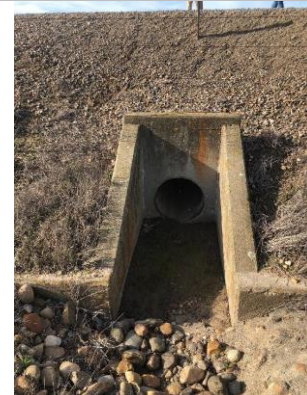
Photo 2 of 3 : UCIP_FA_2023_79023_92562.jpg

LS View: Headwall at LS toe.

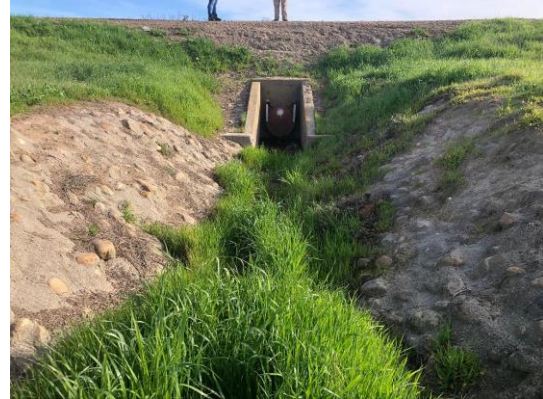
Photo 3 of 3 : UCIP_FA_2023_79023_92565.jpg

WS View: Headwall and flapgate at WS slope.

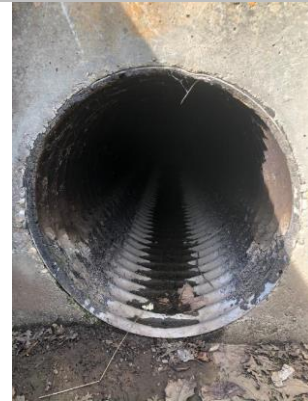
Photo 1 of 2 : UCIP_FA_2023_79024_92552.jpg

Comment Code					
Inspector Comment					
DS_ID:23770 FS_ID:79024 EP_NO: N/A Repair Type: Non-Urgent EVAL Issue: 5, Pipe Damage Crossing Status: Found UCIP Comments: 02/23/2021 Record was updated from No Action Needed to Non-Urgent. DWR DMP has found integrity issues, LOF between 4 and 5. Crossing will be monitored until funding becomes available for rehabilitation. No permit was found authorizing this encroachment. CVFPB will need to review crossing to determine owner. Slight weathering of interior pipe coating observed. The UCIP inspection was completed with LMA representative, J. Caruso. (N. Cholewinski - GEI) FIELD_STRUCT_DESC: 24-inch corrugated metal storm drainage pipe (CMP) through the levee, 6.0 feet below the crown. Flap gate on the waterside (WS) end. Concrete U-shaped headwalls on both ends. Cobble grouted outlet on the WS end. Cobble grouted intake on the landside (LS). [Additional Reference(s): DWR Levee Log, 1990, (HLM 13.60). USACE San Joaquin O&M Manual 612.2, 1967, (HLM 13.60), 24-inch pipe listed]. FS Date: 2/23/2021

LS View: Pipe at LS toe.

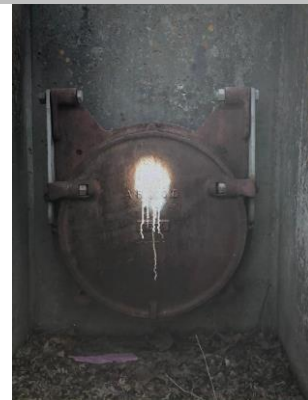
Photo 2 of 2 : UCIP_FA_2023_79024_92555.jpg

WS View: Flapgate at WS slope.

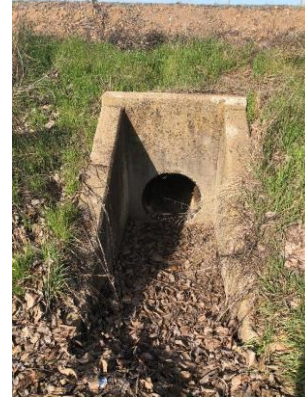
Photo 1 of 2 : UCIP_FA_2023_79025_92534.jpg

Comment Code						
Inspector Comment						
DS_ID:23771						
FS_ID:79025						
EP_NO: N/A						
Repair Type: Non-Urgent						
EVAL Issue:						
Crossing Status: Found						
UCIP Comments: 02/23/2021 Record was updated from No Action						
Needed to Non-Urgent. No permit was found authorizing this						
encroachment. CVFPB will need to review crossing to determine owner.						
DWR DMP has not found internal issues, LOF between 1 and 2.						
Recommend inspection in 5 years. Leaf vegetation build-up present at						
LS toe. The UCIP inspection was completed with LMA representative, J.						
Caruso. (N. Cholewinski – GEI)						
FIELD_STRUCT_DESC: 24-inch corrugated metal storm drainage pipe						
(CMP) through the levee, 6.0 feet below the crown. Flap gate on the						
waterside (WS) end. Concrete U-shaped headwalls on both ends.						
Cobble grouted outlet on the WS end. Cobble grouted intake on the						
landside (LS). [Additional Reference(s): DWR Levee Log, 1990, (HLM

LS View: Headwall at LS toe.

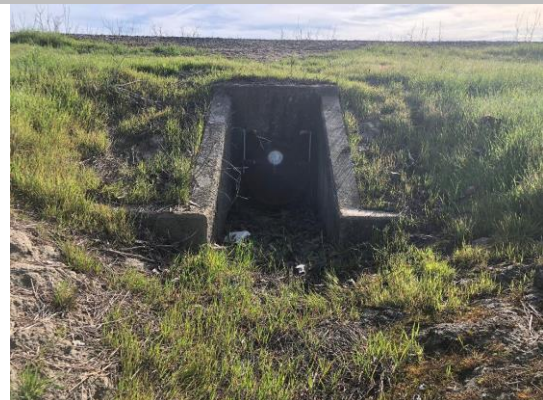
Photo 2 of 2 : UCIP_FA_2023_79025_92537.jpg

WS View: Headwall and flapgate at WS slope.

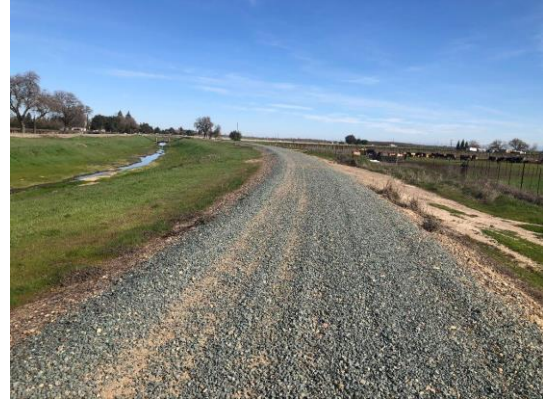
Photo 1 of 3 : UCIP_FA_2023_79416_92517.jpg

Comment Code						
Inspector Comment						
DS_ID:23773 FS_ID:79416 EP_NO: N/A Repair Type: Non-Urgent EVAL Issue: 5, Pipe Damage Crossing Status: Found UCIP Comments: 03/31/2023 Record updated from Urgent to Non-Urgent. LoF is equal to 5.1 due to a pin hole at pipe entrance, other integrity issues are not found. Crossing will be monitored until funding becomes available for rehabilitation. (O.Yakimov - DWR UCIP). 02/23/2021 Record was updated from No Action Needed to Urgent. DWR DMP has found integrity issues, LOF between 5 and 6. Crossing will be monitored until funding becomes available for removal. No permit was found authorizing this encroachment. CVFPB will need to review crossing to determine owner. Slight offset, <1-inch, observed within interior of pipe at approximately 10 feet inside pipe from LS pipe opening. Small gap, approximately 1/4-inch, present at base of pipe along exterior of pipe opening at LS toe. The UCIP inspection was completed with LMA representative, J. Caruso. (N. Cholewinski - GEI) FIELD_STRUCT_DESC: 1 of 2: 36-inch corrugated metal storm drainage pipe (CMP) through the levee, 4.0 feet below the crown. Flap gate on the waterside (WS) end. Concrete U-shaped headwalls on both ends. Cobble grouted outlet on the WS end. Cobble grouted intake on the landside (LS). [Additional Reference(s): DWR Levee Log, 1990, (HLM 14.16). USACE San Joaquin O&M Manual 612.2, 1967, (HLM 14.16), 36-inch pipe listed]. FS Date: 2/23/2021

Crown Overview

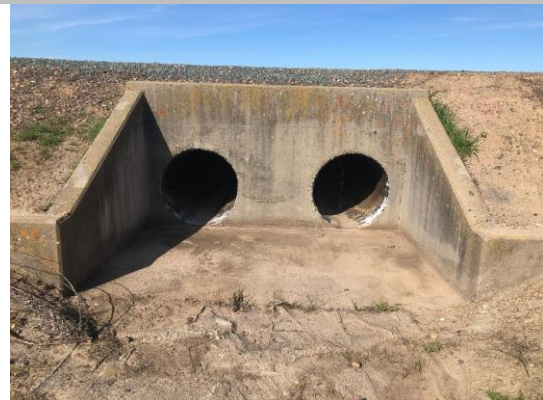
Photo 2 of 3 : UCIP_FA_2023_79416_92519.jpg

LS View: Headwall at LS toe.

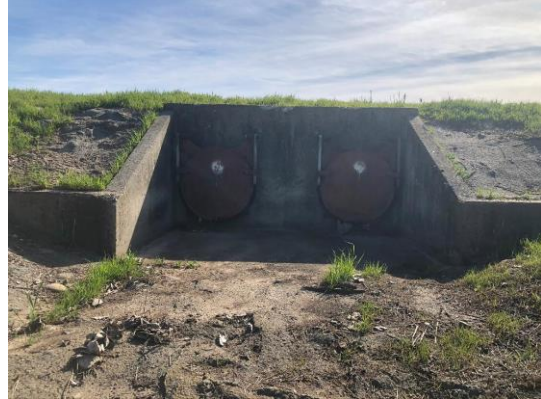
Photo 3 of 3 : UCIP_FA_2023_79416_92524.jpg

WS View: Headwall and flapgate at WS slope.

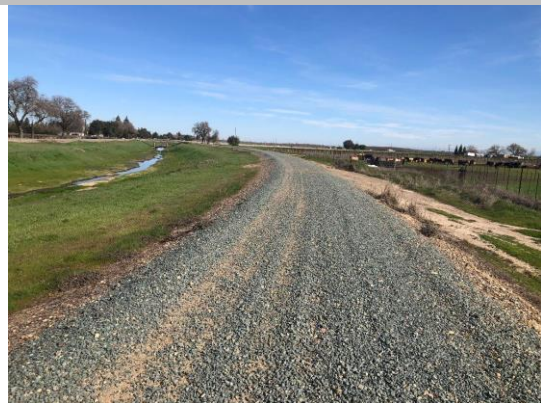
Photo 1 of 3 : UCIP_FA_2023_79027_92508.jpg

DS_ID:23815
 FS_ID:79027
 EP_NO: N/A
 Repair Type: Non-Urgent
 EVAL Issue:
 Crossing Status: Found
 UCIP Comments: 02/23/2021 Record was updated from No Action Needed to Non-Urgent. No permit was found authorizing this encroachment. CVFPB will need to review crossing to determine owner. DWR DMP has not found internal issues, LOF between 1 and 2. Recommend inspection in 5 years. The UCIP inspection was completed with LMA representative, J. Caruso. (N. Cholewinski – GEI)
 FIELD_STRUCT_DESC: 2 of 2: 36-inch corrugated metal storm drainage pipe (CMP) through the levee, 4.0 feet below the crown. Flap gate on the waterside (WS) end. Concrete U-shaped headwalls on both ends. Cobble grouted outlet on the WS end. Cobble grouted intake on the landside (LS). [Additional Reference(s): DWR Levee Log, 1990, (HLM 14.16). USACE San Joaquin O&M Manual 612.2, 1967, (HLM 14.16), 36-inch pipe listed].
 FS Date: 2/23/2021

Crown Overview

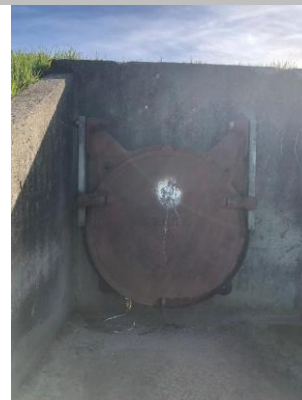
Photo 3 of 3 : UCIP_FA_2023_79027_92514.jpg

WS View: Headwall and flapgate on WS slope.

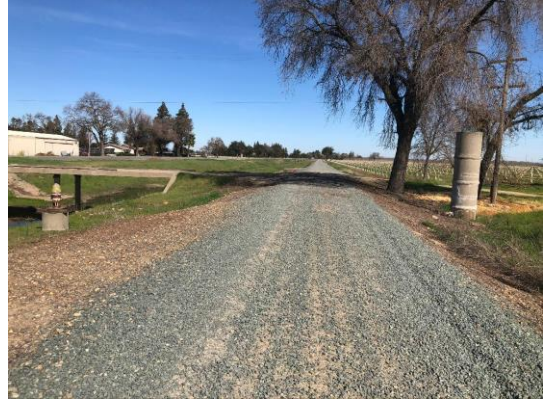
Photo 1 of 3 : UCIP_FA_2023_79028_92493.jpg

Comment Code						
Inspector Comment						
DS_ID:23775 FS_ID:79028 EP_NO: N/A Repair Type: Non-Urgent EVAL Issue: Crossing Status: Found UCIP Comments: 02/23/2021 Record was updated from No Action Needed to Non-Urgent. No permit was found authorizing this encroachment. CVFPB will need to review crossing to determine owner. DWR DMP has not found internal issues, LOF between 1 and 2. Recommend inspection in 5 years. The UCIP inspection was completed with LMA representative, J. Caruso. (N. Cholewinski – GEI) FIELD_STRUCT_DESC: 24-inch corrugated metal storm drainage pipe (CMP) through the levee, 4.0 feet below the crown. Flap gate on the waterside (WS) end. Concrete U-shaped headwalls on both ends. Cobble grouted outlet on the WS end. Cobble grouted intake on the landside (LS). [Additional Reference(s): DWR Levee Log, 1990, (HLM 14.35). USACE San Joaquin O&M Manual 612.2, 1967, (HLM 14.35), 24-inch pipe listed]. FS Date: 2/23/2021

Crown Overview - Storm drain located on upstream side of bridge.

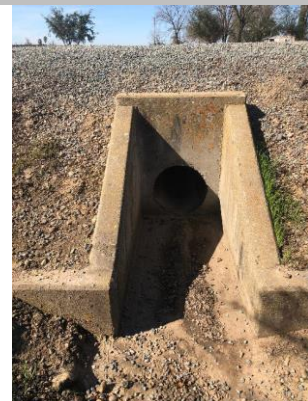
Photo 2 of 3 : UCIP_FA_2023_79028_92495.jpg

LS View: Headwall at LS toe.

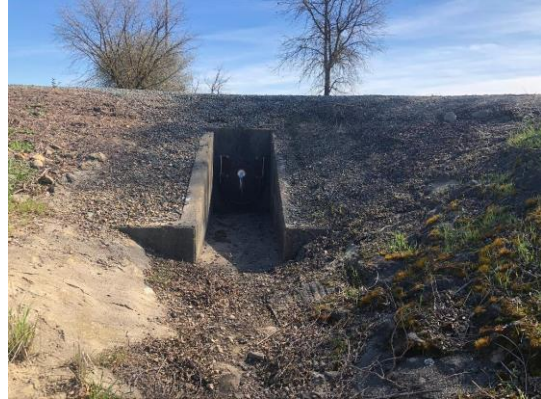
Photo 3 of 3 : UCIP_FA_2023_79028_92498.jpg

WS View: Headwall and 24-inch flapgate at WS slope.

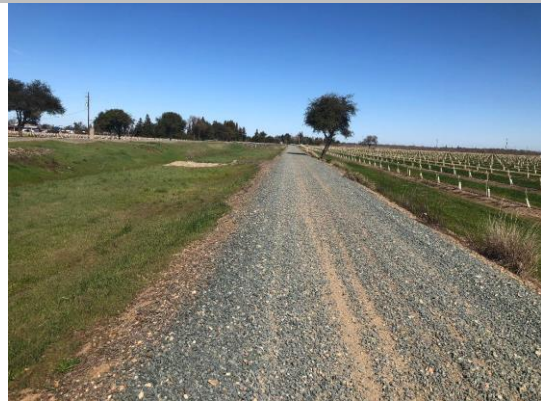
Photo 1 of 3 : UCIP_FA_2023_79029_92485.jpg

DS_ID:23776
 FS_ID:79029
 EP_NO: N/A
 Repair Type: Non-Urgent
 EVAL Issue:
 Crossing Status: Found
 UCIP Comments: 02/23/2021 Pipe status is still Non-Urgent. No permit was found authorizing this encroachment. CVFPB will need to review crossing to determine owner. DWR DMP has not found internal issues, LOF between 1 and 2. Recommend inspection in 5 years. Observed small gap, approximately 1/4-inch wide, at base of pipe on LS toe. The UCIP inspection was completed with LMA representative, J. Caruso. (N. Cholewinski – GEI)05/21/2014 Some silt buildup inside pipe. (W. Wylie - DWR DMP)
 FIELD_STRUCT_DESC: 24-inch corrugated metal storm drainage pipe (CMP) through the levee, 4.0 feet below the crown. Flap gate on the waterside (WS) end. Concrete U-shaped headwalls on both ends. Cobble grouted outlet on the WS end. Cobble grouted intake on the landside (LS). [Additional Reference(s): DWR Levee Log, 1990, (HLM 14.46). USACE San Joaquin O&M Manual 612.2, 1967, (HLM 14.46), 24-inch pipe listed].

Crown Overview

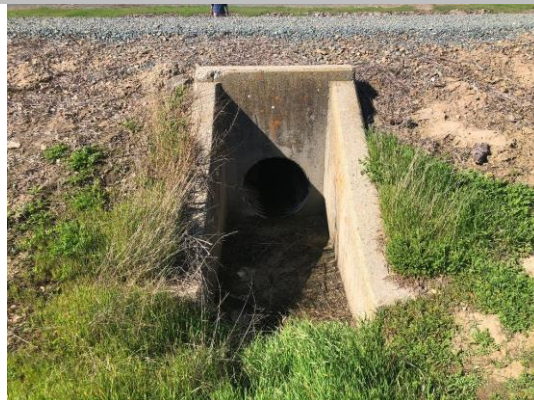
Photo 2 of 3 : UCIP_FA_2023_79029_92487.jpg

LS View: Headwall at LS toe.

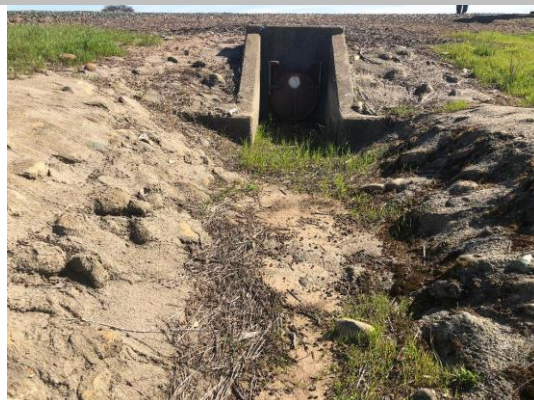
Photo 3 of 3 : UCIP_FA_2023_79029_92491.jpg

WS View: Headwall and flapgate at WS slope.

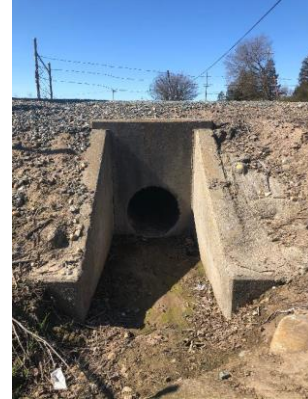
Photo 1 of 2 : UCIP_FA_2023_79030_92472.jpg

Comment Code						
Inspector Comment						
DS_ID:23778 FS_ID:79030 EP_NO: N/A Repair Type: Non-Urgent EVAL Issue: Crossing Status: Found UCIP Comments: 02/23/2021 Pipe status is still Non-Urgent. No permit was found authorizing this encroachment. CVFPB will need to review crossing to determine owner. DWR DMP has not found internal issues, LOF between 1 and 2. Recommend inspection in 5 years. The UCIP inspection was completed with LMA representative, J. Caruso. (N. Cholewinski – GEI)05/21/2014 Some silt buildup inside pipe. (W. Wylie - DWR DMP) FIELD_STRUCT_DESC: 24-inch corrugated metal storm drainage pipe (CMP) through the levee, 4.0 feet below the crown. Flap gate on the waterside (WS) end. Concrete U-shaped headwalls on both ends. Cobble grouted outlet on the WS end. Cobble grouted intake on the landside (LS). [Additional Reference(s): DWR Levee Log, 1990, (HLM 14.69). USACE San Joaquin O&M Manual 612.2, 1967, (HLM 14.69), 24-inch pipe listed]. FS Date: 2/23/2021

LS View: Headwall at LS toe.
