**Flood Control Project Maintenance
Levee Inspections**

Maintenance Issue Types Only, Levee Inspection Report By Mile - Fall 2023

San Joaquin County Flood Control and Water Conservation District

Waterway	Bank	Unit Miles	Inspection Start/End	Inspector
Unit No. 01 Littlejohn Creek	Left	2.59	10/20/2023 10/20/2023	Alberto De Leon

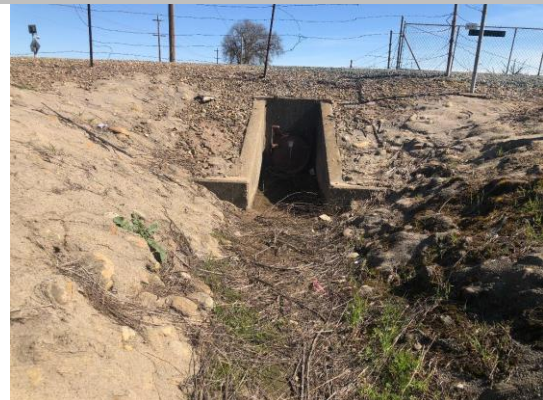
Photo 2 of 2 : UCIP_FA_2023_79030_92475.jpg

Comment Code						
Inspector Comment						
DS_ID:23778 FS_ID:79030 EP_NO: N/A Repair Type: Non-Urgent EVAL Issue: Crossing Status: Found UCIP Comments: 02/23/2021 Pipe status is still Non-Urgent. No permit was found authorizing this encroachment. CVFPB will need to review crossing to determine owner. DWR DMP has not found internal issues, LOF between 1 and 2. Recommend inspection in 5 years. The UCIP inspection was completed with LMA representative, J. Caruso. (N. Cholewinski – GEI)05/21/2014 Some silt buildup inside pipe. (W. Wylie - DWR DMP) FIELD_STRUCT_DESC: 24-inch corrugated metal storm drainage pipe (CMP) through the levee, 4.0 feet below the crown. Flap gate on the waterside (WS) end. Concrete U-shaped headwalls on both ends. Cobble grouted outlet on the WS end. Cobble grouted intake on the landside (LS). [Additional Reference(s): DWR Levee Log, 1990, (HLM 14.69). USACE San Joaquin O&M Manual 612.2, 1967, (HLM 14.69), 24-inch pipe listed]. FS Date: 2/23/2021

WS View: Headwall and flapgate on WS slope.

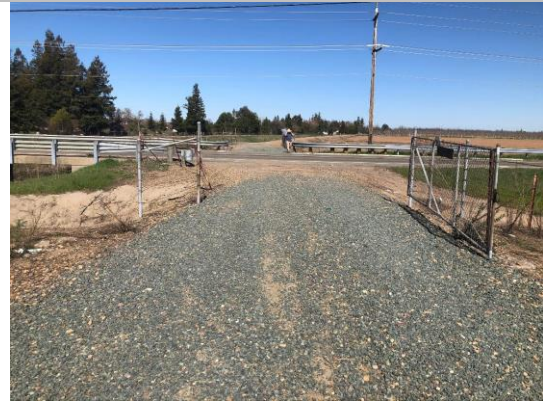
Photo 1 of 3 : UCIP_FA_2023_79031_92457.jpg

Comment Code						
Inspector Comment						
DS_ID:23779 FS_ID:79031 EP_NO: N/A Repair Type: Non-Urgent EVAL Issue: Crossing Status: Found UCIP Comments: 02/23/2021 Record was updated from No Action Needed to Non-Urgent . No permit was found authorizing this encroachment. CVFPB will need to review crossing to determine owner. DWR DMP has not found internal issues, LOF between 1 and 2. Recommend inspection in 5 years. The UCIP inspection was completed with LMA representative, J. Caruso. (N. Cholewinski - GEI) FIELD_STRUCT_DESC: 24-inch corrugated metal storm drainage pipe (CMP) through the levee, 6.5 feet below the crown. Flap gate on the waterside (WS) end. Concrete U-shaped headwalls on both ends. Cobble grouted outlet on the WS end. Cobble grouted intake on the landside (LS). [Additional Reference(s): DWR Levee Log, 1990, (HLM 14.70). USACE San Joaquin O&M Manual 612.2, 1967, (HLM 14.70), 24-inch pipe listed]. FS Date: 2/23/2021

Crown Overview - Utility across road.

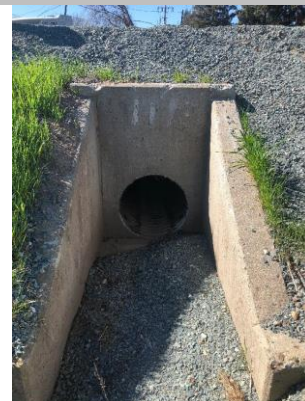
Photo 2 of 3 : UCIP_FA_2023_79031_92459.jpg

LS View: Headwall at LS toe.

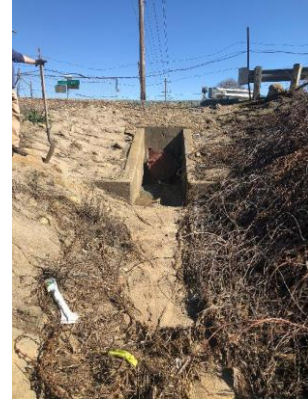
Photo 3 of 3 : UCIP_FA_2023_79031_92463.jpg

WS View: Headwall and flapgate on WS slope.

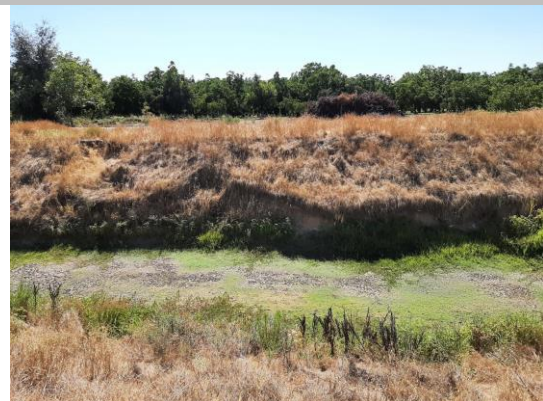
Photo 1 of 1 : FA_2023_NA0017_152_78_20231101_00267.jpg

LM Start	14.67	Rating **	A/W	Issue No.	78
LM End	14.68	Issue Type +	Ma	Location *	WS
Category	Earthen Levee		GPS Latitude/Longitude		
			Start	End	
Item	Erosion / Bank Caving		38.121082°	38.121217°	
			-121.169381°	-121.169306°	
DWR ID	DWR_NA0017_08_f_2023_78

*This area is patrol road only and therefore the site is not rated
07/13/2022: No significant changes were observed during the annual survey.

06/22/2021: A large rodent hole was discovered at the bank toe a few feet upstream of the erosion. Otherwise, no significant changes were observed during the annual survey.

07/31/2020: Observed two scour locations at the toe, beneath the existing erosion, approximately 5 ft long and 3 to 4 high. Also noticed some signs of burrow activity.

08/01/2019: Erosion likely has been caused by rainfall runoff.

View of erosion from opposite bank. July 2022

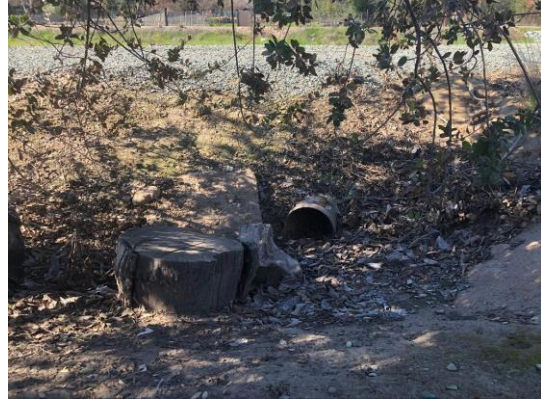
Photo 1 of 3 : UCIP_FA_2023_79032_92451.jpg

Comment Code						
Inspector Comment						
DS_ID:23780 FS_ID:79032 EP_NO: N/A Repair Type: Non-Urgent EVAL Issue: 5, Pipe Damage Crossing Status: Found UCIP Comments: 02/23/2021 Record was updated from No Action Needed to Non-Urgent. DWR DMP has found integrity issues, LOF between 4 and 5. Crossing will be monitored until funding becomes available for rehabilitation. No permit was found authorizing this encroachment. CVFPB will need to review crossing to determine owner. The UCIP inspection was completed with LMA representative, J. Caruso. (N. Cholewinski - GEI) FIELD_STRUCT_DESC: 12-inch corrugated metal storm drainage pipe (CMP) through the levee, 3.0 feet below the crown. Flap gate on the waterside (WS) end. Cobble grouted outlet on the WS end. Cobble grouted intake on the landside (LS). [Additional Reference(s): DWR Levee Log, 1990, (HLM 15.08). USACE San Joaquin O&M Manual 612.2, 1967, (HLM 15.08), 12-inch pipe listed]. FS Date: 2/23/2021

LS View: CM pipe at LS toe.

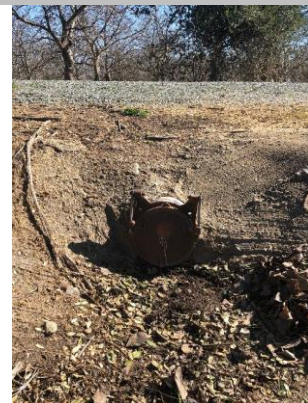
Photo 2 of 3 : UCIP_FA_2023_79032_92454.jpg

WS View: CM pipe and flapgate on WS slope.

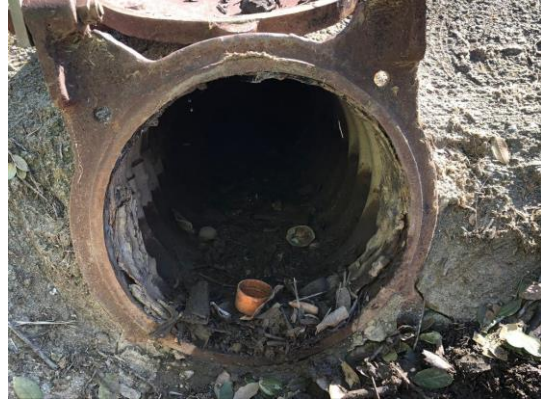
Photo 3 of 3 : UCIP_FA_2023_79032_92455.jpg

WS View: Pipe slightly corroded at outlet. Moisture observed in pipe, possible leakage occurring.

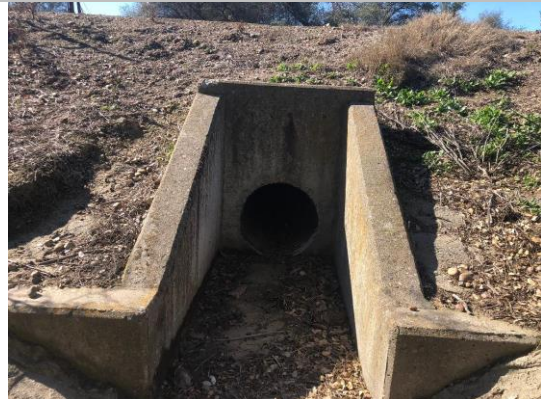
Photo 1 of 3 : UCIP_FA_2023_79033_92398.jpg

DS_ID:23781
 FS_ID:79033
 EP_NO: N/A
 Repair Type: Non-Urgent
 EVAL Issue:
 Crossing Status: Found
 UCIP Comments: 02/23/2021 Record was updated from No Action Needed to Non-Urgent. No permit was found authorizing this encroachment. CVFPB will need to review crossing to determine owner. DWR DMP has not found internal issues, LOF between 1 and 2. Recommend inspection in 5 years. Tree on downstream side of WS headwall is causing slight separation between headwall and apron, 1- to 2-inch gap. The UCIP inspection was completed with LMA representative, J. Caruso. (N. Cholewinski - GEI)
 FIELD_STRUCT_DESC: 24-inch corrugated metal storm drainage pipe (CMP) through the levee, 6.0 feet below the crown. Flap gate on the waterside (WS) end. Concrete U-shaped headwalls on both ends. Cobble grouted outlet on the WS end. Cobble grouted intake on the landside (LS). [Additional Reference(s): DWR Levee Log, 1990, (HLM 15.24). USACE San Joaquin O&M Manual 612.2, 1967, (HLM 15.24), 24-inch pipe listed].

LS View: Headwall at LS toe.

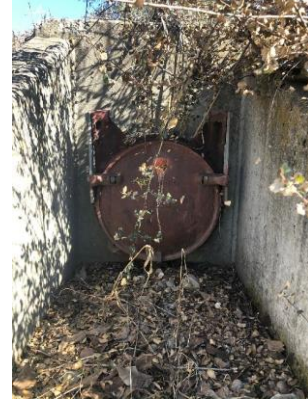
Photo 2 of 3 : UCIP_FA_2023_79033_92408.jpg

WS View: 24-inch flapgate at WS slope.

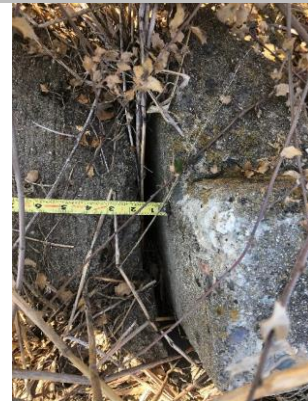
Photo 3 of 3 : UCIP_FA_2023_79033_92415.jpg

WS View: Gap observed between headwall and apron on downstream side.

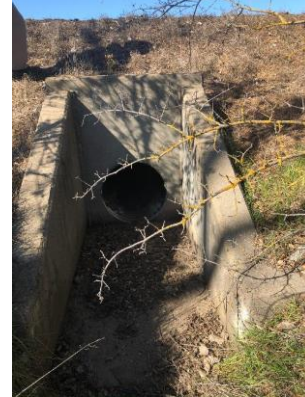
Photo 1 of 3 : UCIP_FA_2023_79034_92360.jpg

Comment Code					
Inspector Comment					
DS_ID:23782 FS_ID:79034 EP_NO: N/A Repair Type: Non-Urgent EVAL Issue: Crossing Status: Found UCIP Comments: 02/23/2021 Record was updated from No Action Needed to Non-Urgent No permit was found authorizing this encroachment. CVFPB will need to review crossing to determine owner. DWR DMP has not found internal issues, LOF between 1 and 2. Recommend inspection in 5 years. The UCIP inspection was completed with LMA representative, J. Caruso. (N. Cholewinski - GEI) FIELD_STRUCT_DESC: 24-inch corrugated metal storm drainage pipe (CMP) through the levee, 6.0 feet below the crown. Flap gate on the waterside (WS) end. Concrete U-shaped headwalls on both ends. Cobble grouted outlet on the WS end. Cobble grouted intake on the landside (LS). [Additional Reference(s): DWR Levee Log, 1990, (HLM 15.44). USACE San Joaquin O&M Manual 612.2, 1967, (HLM 15.44), 24-inch pipe listed]. FS Date: 2/23/2021

LS View: Headwall at LS toe.

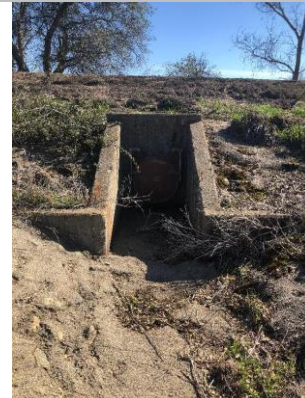
Photo 2 of 3 : UCIP_FA_2023_79034_92366.jpg

WS View: Headwall and flapgate on WS slope.

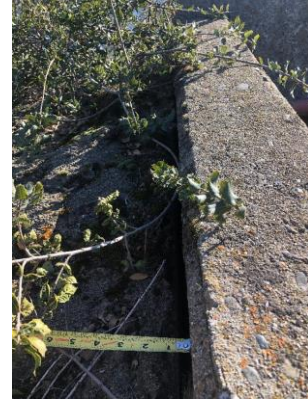
Photo 3 of 3 : UCIP_FA_2023_79034_92367.jpg

WS View: Small gap present on upstream side of headwall.

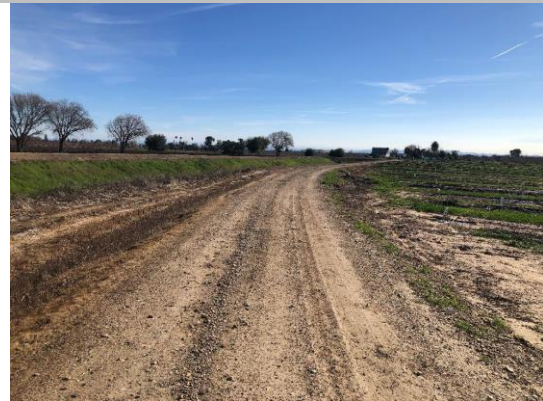
Photo 1 of 3 : UCIP_FA_2023_79035_92186.jpg

DS_ID:23784
 FS_ID:79035
 EP_NO: N/A
 Repair Type: Non-Urgent
 EVAL Issue:
 Crossing Status: Found
 UCIP Comments: 02/25/2021 Record changed from No Action Needed to Non-Urgent. No permit was found authorizing this encroachment. CVFPB will need to review crossing to determine owner. DWR DMP has not found internal issues, LOF between 1 and 2. Recommend inspection in 5 years. Observed slight damage to concrete on LS headwall toe, but no noticeable integrity issues. The UCIP inspection was completed with LMA representative, J. Caruso. (N. Cholewinski - GEI)
 FIELD_STRUCT_DESC: 24-inch corrugated metal storm drainage pipe (CMP) through the levee, 3.0 feet below the crown. Flap gate on the waterside (WS) end. Concrete U-shaped headwalls on both ends. Cobble grouted outlet on the WS end. Cobble grouted intake on the landside (LS). [Additional Reference(s): DWR Levee Log, 1990, (HLM 16.02). USACE San Joaquin O&M Manual 612.2, 1967, (HLM 16.02), 24-inch pipe listed].

Top of Levee

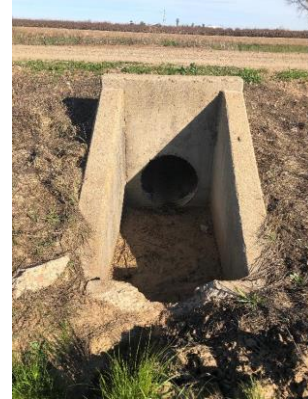
Photo 2 of 3 : UCIP_FA_2023_79035_92188.jpg

LS View: Headwall at LS toe.

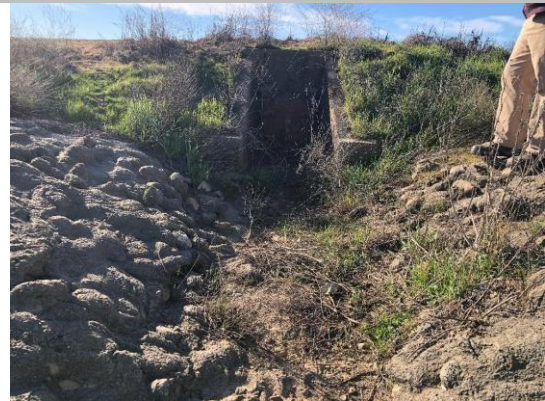
Photo 3 of 3 : UCIP_FA_2023_79035_92192.jpg

WS View: Headwall and 24-inch flapgate at WS slope.

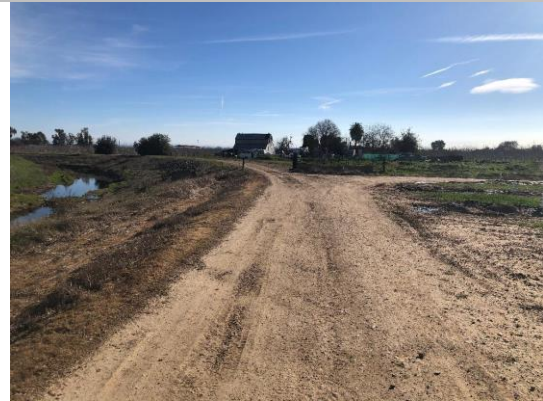
Photo 1 of 3 : UCIP_FA_2023_79036_92179.jpg

Comment Code						
Inspector Comment						
DS_ID:23785 FS_ID:79036 EP_NO: N/A Repair Type: Non-Urgent EVAL Issue: Crossing Status: Found UCIP Comments: 02/25/2021 Record changed from No Action Needed to Non-Urgent. No permit was found authorizing this encroachment. CVFPB will need to review crossing to determine owner. DWR DMP has not found internal issues, LOF between 1 and 2. Recommend inspection in 5 years. The UCIP inspection was completed with LMA representative, J. Caruso. (N. Cholewinski - GEI) FIELD_STRUCT_DESC: 24-inch corrugated metal storm drainage pipe (CMP) through the levee, 1.5 feet below the crown. Flap gate on the waterside (WS) end. Concrete U-shaped headwalls on both ends. Cobble grouted outlet on the WS end. Cobble grouted intake on the landside (LS). [Additional Reference(s): DWR Levee Log, 1990, (HLM 16.15). USACE San Joaquin O&M Manual 612.2, 1967, (HLM 16.15), 24-inch pipe listed]. FS Date: 2/25/2021

Top of Levee

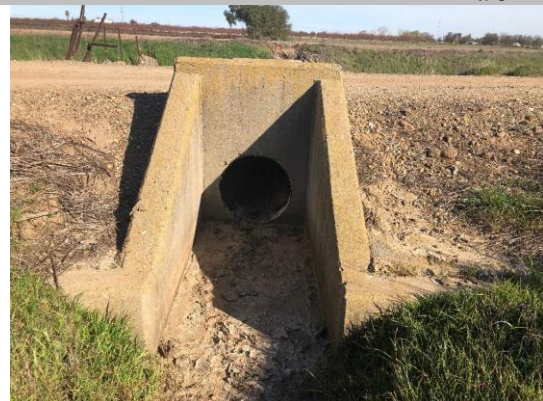
Photo 2 of 3 : UCIP_FA_2023_79036_92181.jpg

LS View: Headwall at LS toe.

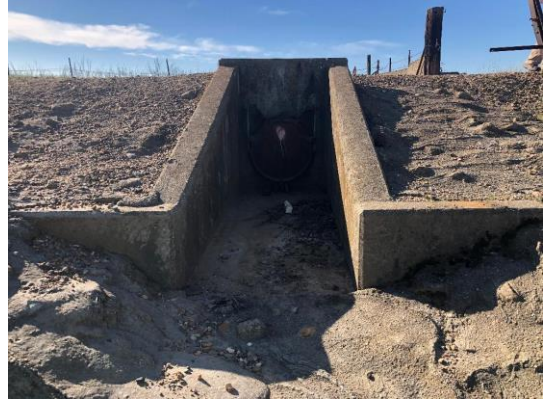
Photo 3 of 3 : UCIP_FA_2023_79036_92184.jpg

WS View: Headwall and 24-inch flapgate at WS slope.

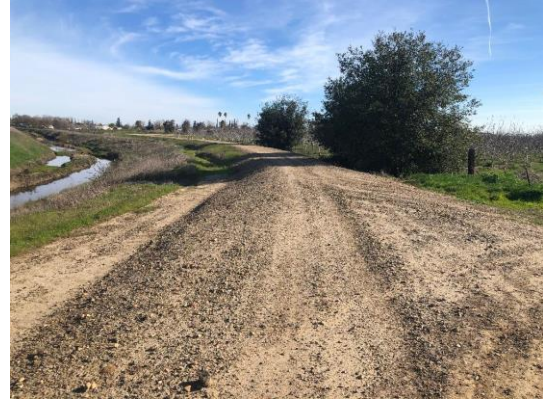
Photo 1 of 3 : UCIP_FA_2023_79417_92169.jpg

Comment Code					
Inspector Comment					
DS_ID:23786 FS_ID:79417 EP_NO: N/A Repair Type: Non-Urgent EVAL Issue: 5, Pipe Damage Crossing Status: Found UCIP Comments: 03/31/2023 Record updated from Urgent to Non-Urgent. LoF is equal to 5.1 due to a small hole near waterside pipe end, other integrity issues were not found. Crossing will be monitored until funding becomes available for rehabilitation. (O.Yakimov - DWR UCIP). 02/25/2021 Record was updated from No Action Needed to Urgent due to a corroded through pipe wall at the WS pipe outlet and leakage observed at the LS pipe inlet. DWR DMP has found integrity issues, LOF between 5 and 6. Crossing will be monitored until funding becomes available for removal. No permit was found authorizing this encroachment. CVFPB will need to review crossing to determine owner. An additional 1-inch steel pipe oriented parallel to levee was observed approximately 1 foot adjacent to LS headwall at LS toe. The UCIP inspection was completed with LMA representative, J. Caruso. (N. Cholewinski - GEI) FIELD_STRUCT_DESC: 24-inch corrugated metal storm drainage pipe (CMP) through the levee, 8.0 feet below the crown. Flap gate on the waterside (WS) end. Concrete U-shaped headwalls on both ends. Cobble grouted outlet on the WS end. Cobble grouted intake on the landside (LS). [Additional Reference(s): DWR Levee Log, 1990, (HLM 16.22). USACE San Joaquin O&M Manual 612.2, 1967, (HLM 16.22), 24-inch pipe listed]. FS Date: 2/25/2021

Top of Levee

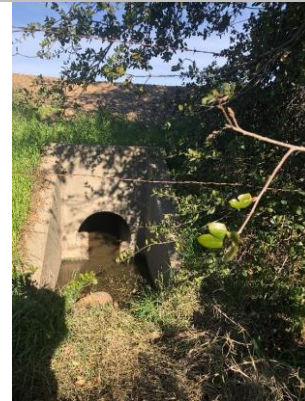
Photo 2 of 3 : UCIP_FA_2023_79417_92171.jpg

Headwall at LS toe.

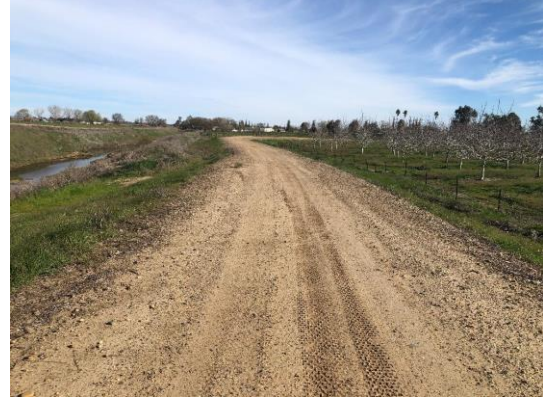
Photo 1 of 3 : UCIP_FA_2023_79038_92159.jpg

Comment Code					
Inspector Comment					
DS_ID:23787 FS_ID:79038 EP_NO: N/A Repair Type: Non-Urgent EVAL Issue: Crossing Status: Found UCIP Comments: 02/25/2021 Record changed from No Action Needed to Non-Urgent. No permit was found authorizing this encroachment. CVFPB will need to review crossing to determine owner. DWR DMP has not found internal issues, LOF between 1 and 2. Recommend inspection in 5 years. The UCIP inspection was completed with LMA representative, J. Caruso. (N. Cholewinski - GEI) FIELD_STRUCT_DESC: 24-inch corrugated metal storm drainage pipe (CMP) through the levee, 6.0 feet below the crown. Flap gate on the waterside (WS) end. Concrete U-shaped headwalls on both ends. Cobble grouted outlet on the WS end. Cobble grouted intake on the landside (LS). [Additional Reference(s): DWR Levee Log, 1990, (HLM 16.27). USACE San Joaquin O&M Manual 612.2, 1967, (HLM 16.27), 24-inch pipe listed]. FS Date: 2/25/2021

Crown Overview

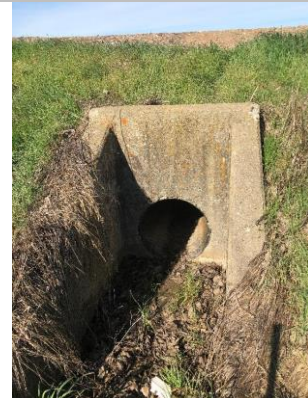
Photo 2 of 3 : UCIP_FA_2023_79038_92162.jpg

Concrete headwall on LS toe.

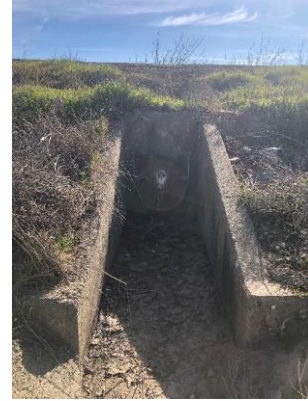
Photo 3 of 3 : UCIP_FA_2023_79038_92167.jpg

Headwall with 24-inch flapgate at WS toe.

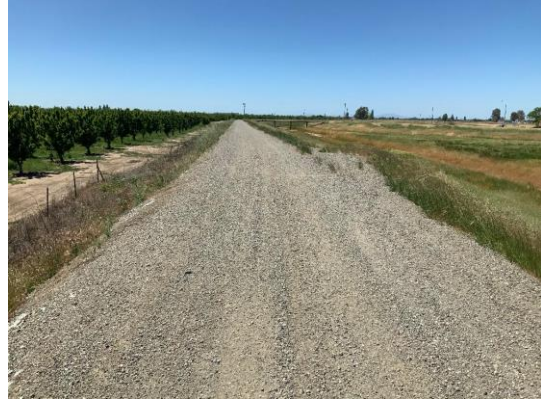
Photo 1 of 3 : UCIP_FA_2023_79040_96876.jpg

Comment Code						
Inspector Comment						
DS_ID:23850 FS_ID:79040 EP_NO: N/A Repair Type: Non-Urgent EVAL Issue: Crossing Status: Found UCIP Comments: 04/27/2021 The record has been upgraded from No Action Needed to Non-Urgent. DWR DMP internal inspection has not found pipe integrity issues. LOF of crossing is less or equal to 4.0. Recommend next inspection in 5 years. No permit was found authorizing this encroachment. CVFPB will need to review crossing to determine owner. The UCIP inspection was completed with LMA representative, J. Nelson. (H. Dunn – GEI) FIELD_STRUCT_DESC: 24-inch corrugated metal storm drainage pipe (CMP) through the levee, 9.5 feet below the crown. Flap gate on the waterside (WS) end. Concrete U-shaped headwalls on both ends. Cobble grouted outlet on the WS end. Cobble grouted intake on the landside (LS). [Additional Reference(s): DWR Levee Log, 1977, 1978, 1987, 1990, (HLM 0.10). USACE San Joaquin O&M Manual 612.2, 1967, (HLM 0.10), Unit 7 (HLM 7.19–16.77), Unit 8 (HLM 7.55–16.48), Unit 9 (HLM 0.10–1.52), Unit 10 (HLM 0.03–1.35), Unit 11 (HLM 0.16–3.55), Unit 12 (HLM 0.14–3.91), Unit 13 (HLM 0.03–1.18), Unit 14 (HLM 0.02–1.17), and 612 (addendum), February 1999, 24-inch pipe listed]. FS Date: 4/27/2021

Levee crown looking downstream.

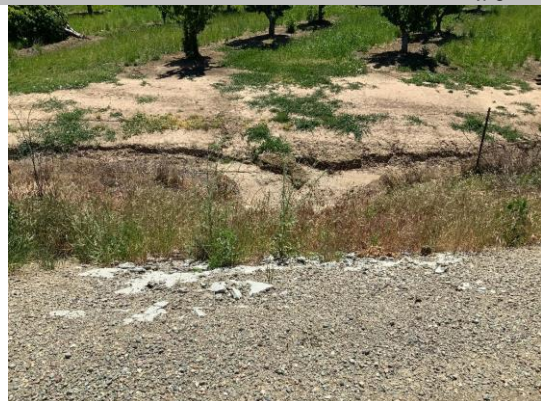
Photo 2 of 3 : UCIP_FA_2023_79040_96877.jpg

LS view: Toe from crown.

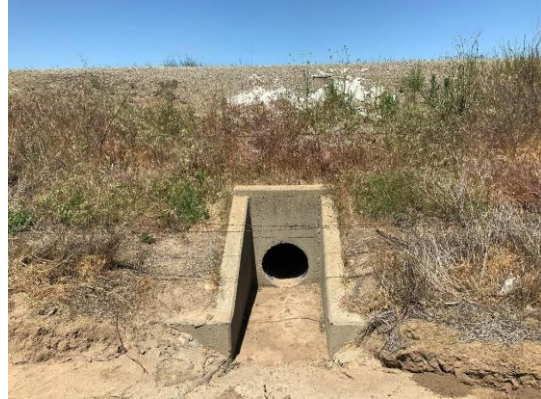
Photo 3 of 3 : UCIP_FA_2023_79040_96878.jpg

LS view: Slope and headwall from toe.

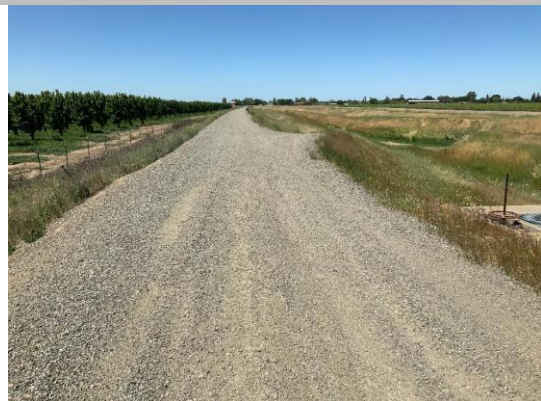
Photo 1 of 3 : UCIP_FA_2023_79041_96884.jpg

DS_ID:23852
 FS_ID:79041
 EP_NO: N/A
 Repair Type: Non-Urgent
 EVAL Issue:
 Crossing Status: Found
 UCIP Comments: 04/27/2021 The record has been upgraded from No Action Needed to Non-Urgent. DWR DMP internal inspection has not found pipe integrity issues. LOF of crossing is less or equal to 4.0. Recommend next inspection in 5 years. The UCIP inspection was completed with LMA representative, J. Nelson. (H. Dunn – GEI)
 FIELD_STRUCT_DESC: 30-inch reinforced concrete (RC) storm drainage pipe through the levee, 8.0 feet below the crown. Concrete U-shaped headwalls on both ends. Slide gate inside a 7-foot by 7-foot concrete box on the waterside (WS) shoulder. [Additional Reference(s): DWR Levee Log, 1987, (HLM 0.45). USACE San Joaquin O&M Manual 612 (addendum), February 1999, (HLM 0.44), (Station 23+20), 24-inch pipe listed].
 FS Date: 4/27/2021

Levee crown looking downstream.

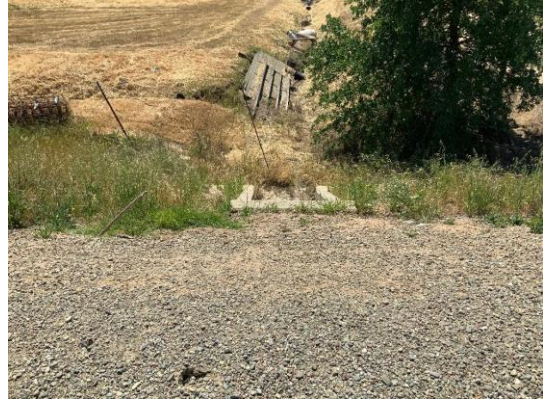
Photo 2 of 3 : UCIP_FA_2023_79041_96885.jpg

LS view: Headwall visible at toe from crown.

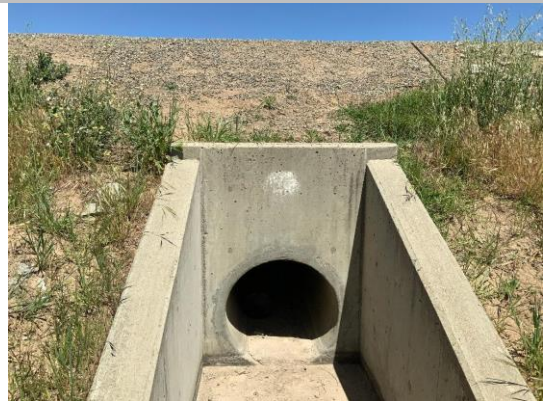
Photo 3 of 3 : UCIP_FA_2023_79041_96886.jpg

LS view: Slope and headwall from toe.

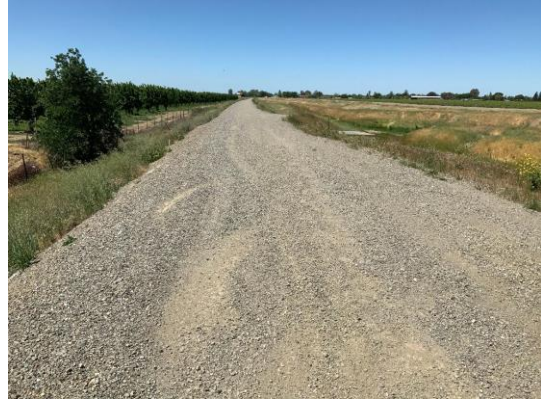
Photo 1 of 3 : UCIP_FA_2023_78577_96889.jpg

Comment Code						
Inspector Comment						
DS_ID:23856 FS_ID:78577 EP_NO: N/A Repair Type: Non-Urgent EVAL Issue: Crossing Status: Not Found UCIP Comments: 04/27/2021 The record has been upgraded from No Action Needed to Non-Urgent. Pipe not found by visual inspection. No permit was found authorizing this encroachment. CVFPB will need to review crossing to determine owner. The UCIP inspection was completed with LMA representative, J. Nelson. (H. Dunn – GEI) FIELD_STRUCT_DESC: 24-inch storm drainage pipe of an unknown material through the levee, at an unknown depth. Drainage structure at this location. [Additional Reference(s): USACE San Joaquin O&M Manual 612 (addendum), February 1999, (HLM 0.44), (Station 23+20), 24-inch pipe listed]. FS Date: 4/27/2021

Levee crown looking downstream.

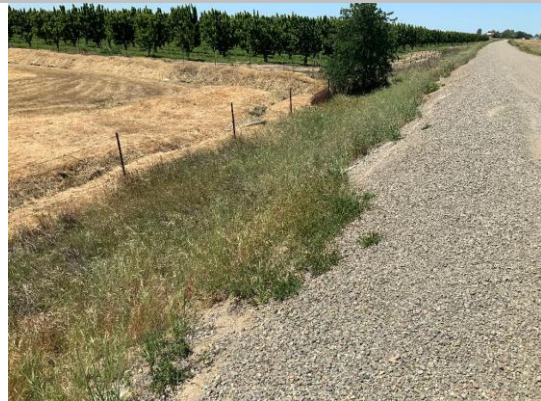
Photo 2 of 3 : UCIP_FA_2023_78577_96888.jpg

LS view: Slope from crown, no pipe visible.

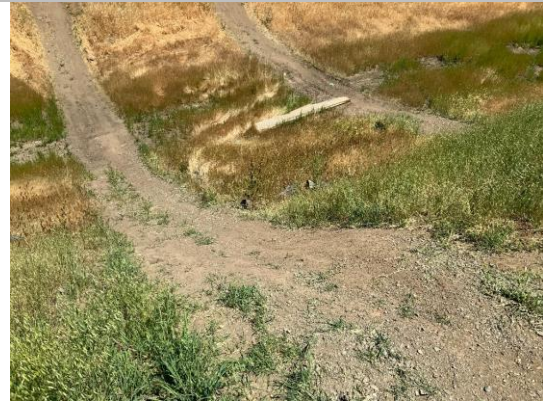
Photo 3 of 3 : UCIP_FA_2023_78577_96890.jpg

WS view: Slope from crown, no pipe visible.

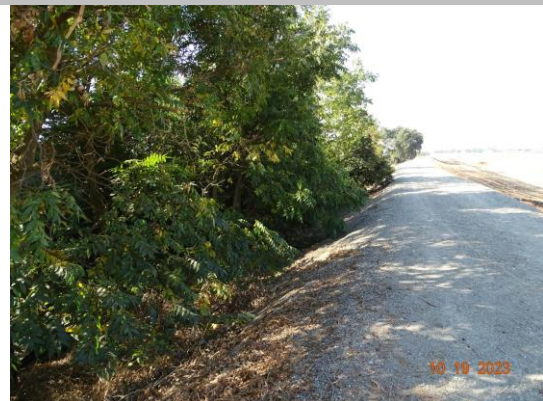
Photo 1 of 1 : FA_2023_NA0017_153_24_20231030_00052.jpg

LM Start	0.51	Rating **	U	Issue No.	24
LM End	0.54	Issue Type +	Ma	Location *	LS
Category	Earthen Levee			GPS Latitude/Longitude	
				Start	End
Item	Trim / Thin Trees			38.094812°	38.094810°
				-121.167519°	-121.167070°
DWR ID	DWR_NA0017_09_f_2022_24				
Comment Code					
T1 : Trim and thin trees to at least five feet above ground level to allow visibility of the ground and room to flood fight.					
Inspector Comment

View of untrimmed trees blocking visibility of landside easement. Fall 2023

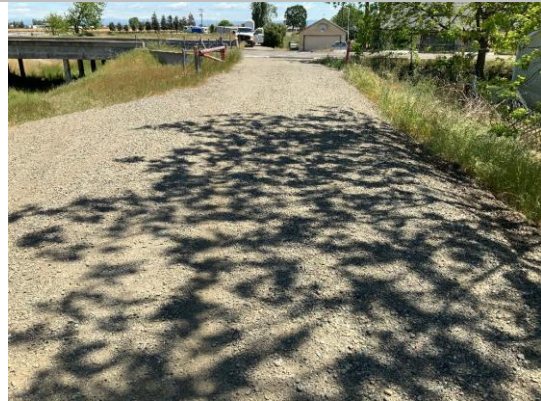
Photo 1 of 3 : UCIP_FA_2023_79042_96893.jpg

DS_ID:23853
FS_ID:79042
EP_NO: N/A
Repair Type: Non-Urgent
EVAL Issue:
Crossing Status: Found
UCIP Comments: 04/27/2021 The record has been upgraded from No Action Needed to Non-Urgent. DWR DMP internal inspection has not found pipe integrity issues. LOF of crossing is less or equal to 4.0. Recommend next inspection in 5 years. No permit was found authorizing this encroachment. CVFPB will need to review crossing to determine owner. The UCIP inspection was completed with LMA representative, J. Nelson. (H. Dunn – GEI)
FIELD_STRUCT_DESC: 24-inch corrugated metal storm drainage pipe (CMP) through the levee, 4.5 feet below the crown. Flap gate on the waterside (WS) end. Concrete U-shaped headwalls on both ends. Cobble grouted outlet on the WS end. Cobble grouted intake on the landside (LS). [Additional Reference(s): DWR Levee Log, 1987, (HLM 0.56). USACE San Joaquin O&M Manual 612.2, 1967, (HLM 0.56), 24-inch pipe listed].

Levee crown looking upstream.

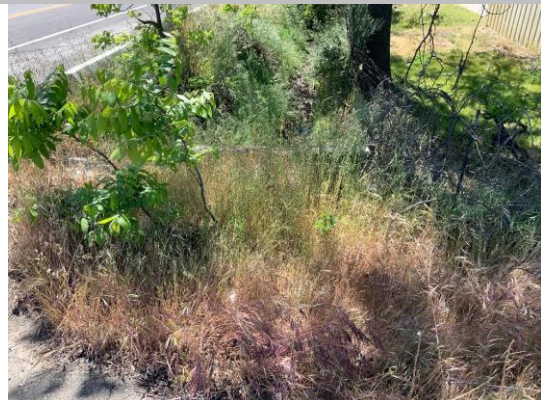
Photo 2 of 3 : UCIP_FA_2023_79042_96894.jpg

LS view: Toe from crown.

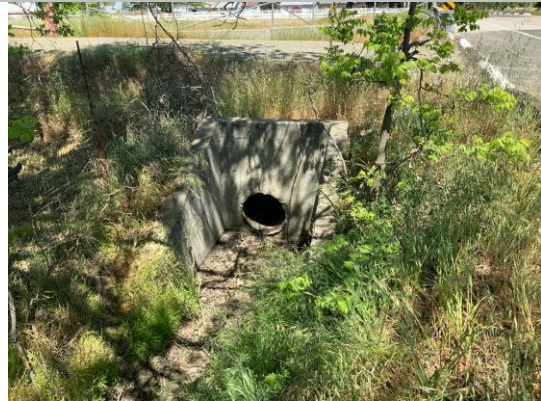
Photo 3 of 3 : UCIP_FA_2023_79042_96895.jpg

LS view: Slope and headwall at toe.

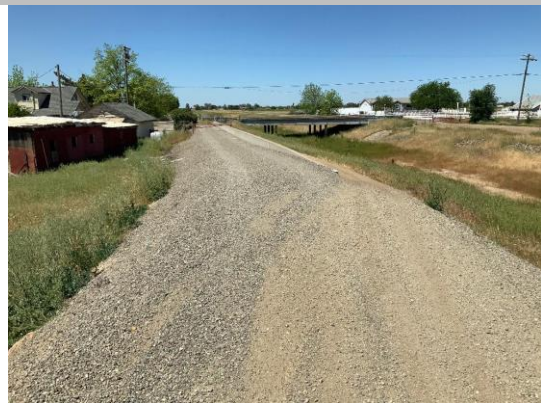
Photo 1 of 3 : UCIP_FA_2023_79043_96901.jpg

DS_ID:23839
FS_ID:79043
EP_NO: N/A
Repair Type: No Action Needed
EVAL Issue:
Crossing Status: Found
UCIP Comments: 04/27/2021 Pipe status is still No Action Needed. DWR DMP internal inspection has not found pipe integrity issues. LOF of crossing is less or equal to 4.0. Recommend next inspection in 5 years. The UCIP inspection was completed with LMA representative, J. Nelson. (H. Dunn – GEI) 06/19/2014 Suction hose and appurtenances appear to be abandoned. (W. Wylie - DWR UCIP)
FIELD_STRUCT_DESC: 24-inch corrugated metal storm drainage pipe (CMP) through the levee, 8.0 feet below the crown. Flap gate on the waterside (WS) end. Concrete U-shaped headwalls on both ends. Cobble grouted outlet on the WS end. Cobble grouted intake on the landside (LS). Pump with suction hose sleeved through the storm drainage pipe located on the LS—removed during winter months. (Suction hose authorized under Permit No. 11530, 1976 - Constantine M. Copulos). [Additional Reference(s): DWR Levee Log, 1987, (HLM 0.62). USACE San Joaquin O&M Manual 612.2, 1967, (HLM 0.62), and 612 (addendum), February 1999, (HLM 0.61), (Station 32+46), 24-inch pipe listed].

Levee crown looking downstream.

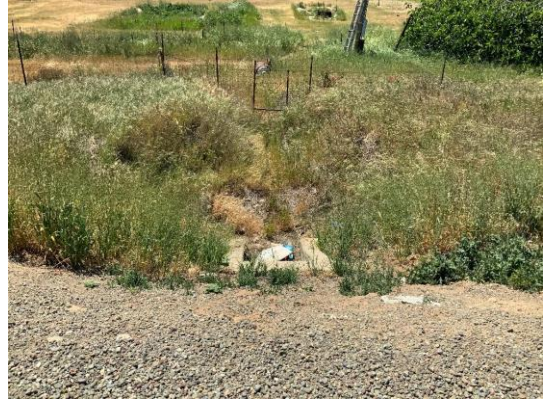
Photo 2 of 3 : UCIP_FA_2023_79043_96902.jpg

LS view: Headwall visible at toe from crown.

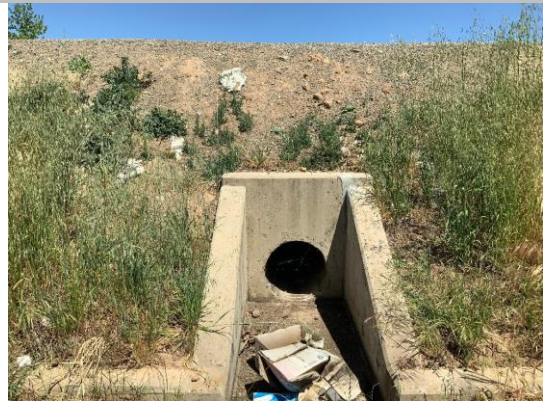
Photo 3 of 3 : UCIP_FA_2023_79043_96903.jpg

LS view: Slope and headwall at toe.

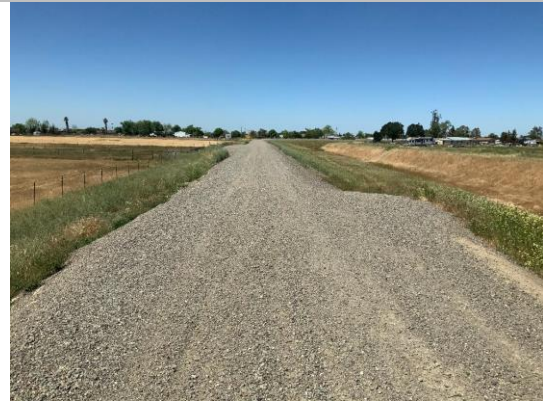
Photo 1 of 3 : UCIP_FA_2023_79044_96906.jpg

Comment Code					
Inspector Comment					
DS_ID:23840 FS_ID:79044 EP_NO: N/A Repair Type: Non-Urgent EVAL Issue: Crossing Status: Found UCIP Comments: 04/27/2021 The record has been upgraded from No Action Needed to Non-Urgent. Did not inspect LS headwall due to steep slope and slippery rubble. DWR DMP internal inspection has not found pipe integrity issues. LOF of crossing is less or equal to 4.0. Recommend next inspection in 5 years. No permit was found authorizing this encroachment. CVFPB will need to review crossing to determine owner. The UCIP inspection was completed with LMA representative, J. Nelson. (H. Dunn – GEI) FIELD_STRUCT_DESC: 24-inch corrugated metal storm drainage pipe (CMP) through the levee, 7.0 feet below the crown. Flap gate on the waterside (WS) end. Concrete U-shaped headwalls on both ends. Cobble grouted outlet on the WS end. Cobble grouted intake on the landside (LS). [Additional Reference(s): DWR Levee Log, 1987, (HLM 0.86). USACE San Joaquin O&M Manual 612.2, 1967, (HLM 0.86), 24-inch pipe listed]. FS Date: 4/27/2021

Levee crown looking downstream.

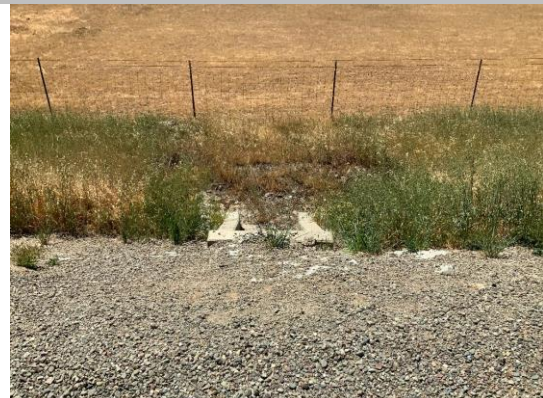
Photo 2 of 3 : UCIP_FA_2023_79044_96907.jpg

LS view: Headwall visible at toe from crown.

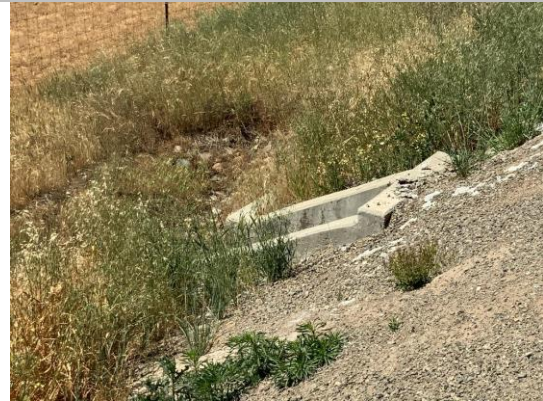
Photo 3 of 3 : UCIP_FA_2023_79044_96905.jpg

LS view: Slope and headwall from crown.

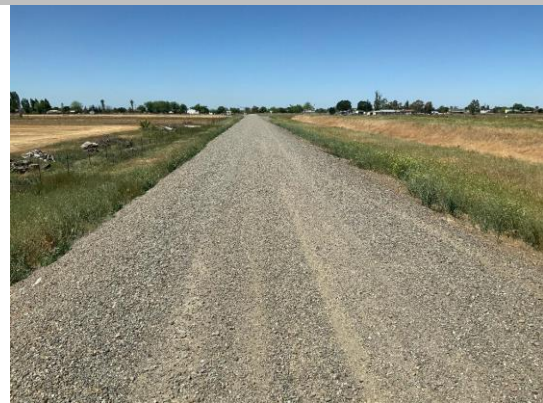
Photo 1 of 3 : UCIP_FA_2023_79045_96917.jpg

DS_ID:23841
 FS_ID:79045
 EP_NO: N/A
 Repair Type: No Action Needed
 EVAL Issue:
 Crossing Status: Found
 UCIP Comments: 09/18/2023 Record updated from Non-Urgent to No Action Needed. Pipe was CIPP lined. DMP internal video inspection has found none or minor pipe defects. Recommend next video inspection in 5 years. (O. Yakimov - DWR UCIP)
 04/27/2021 Pipe status is still Non-Urgent. DWR DMP internal inspection has found pipe integrity issues. LOF of crossing is between 4.1 and 5. Crossing will be monitored until funding becomes available for rehabilitation. No permit was found authorizing this encroachment. CVFPB will need to review crossing to determine owner. The UCIP inspection was completed with LMA representative, J. Nelson. (H. Dunn – GEI) 06/19/2014 Sediment buildup inside pipe. (W. Wylie -DWR UCIP)
 FIELD_STRUCT_DESC: 12-inch CIPP-lined corrugated metal storm drainage pipe (CMP) through the levee, 7.0 feet below the crown. Flap gate on the waterside (WS) end. Headwall at the landside (LS) toe. Cobble grouted outlet on the WS end. [Additional Reference(s): DWR Levee Log, 1987, (HLM 0.94). USACE San Joaquin O&M Manual 612 (addendum), February 1999, (HLM 0.93), (Station 49+30), 12-inch pipe listed].

Levee crown looking downstream.

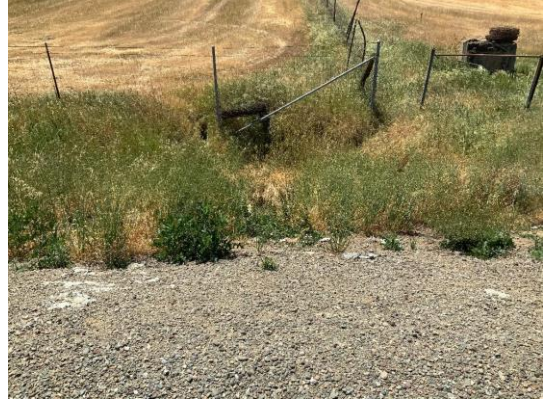
Photo 2 of 3 : UCIP_FA_2023_79045_96919.jpg

LS view: Toe from crown.

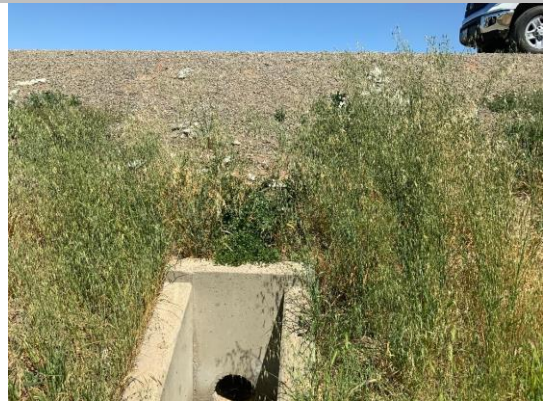
Photo 3 of 3 : UCIP_FA_2023_79045_96920.jpg

LS view: Slope from toe.

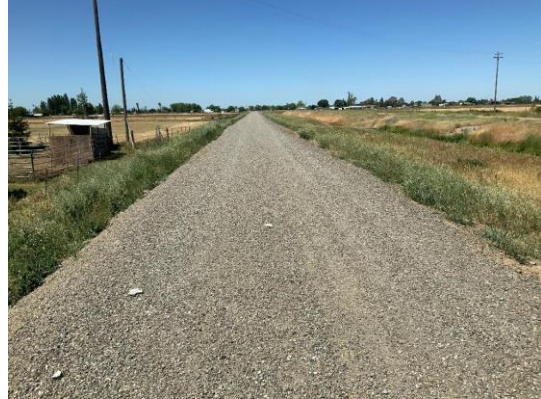
Photo 1 of 3 : UCIP_FA_2023_78583_96922.jpg

Comment Code						
Inspector Comment						
DS_ID:23858 FS_ID:78583 EP_NO: N/A Repair Type: Non-Urgent EVAL Issue: Crossing Status: Not Found UCIP Comments: 04/27/2021 The record has been upgraded from No Action Needed to Non-Urgent. Pipe not found by visual inspection. No permit was found authorizing this encroachment. CVFPB will need to review crossing to determine owner. The UCIP inspection was completed with LMA representative, J. Nelson. (H. Dunn – GEI) FIELD_STRUCT_DESC: 24-inch corrugated metal storm drainage pipe (CMP) through the levee, at an unknown depth. [Additional Reference(s): USACE San Joaquin O&M Manual 612 (addendum), February 1999, (HLM 1.02), (Station 54+05), 24-inch pipe listed]. FS Date: 4/27/2021

Levee crown looking downstream.

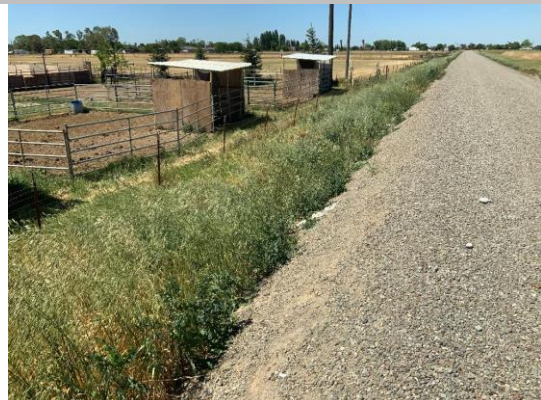
Photo 2 of 3 : UCIP_FA_2023_78583_96923.jpg

LS view: Slope from crown, no pipe visible.

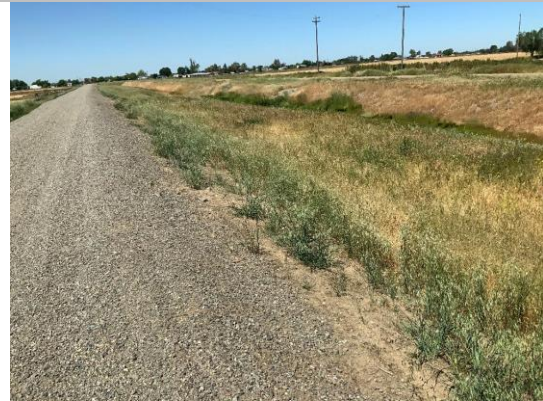
Photo 3 of 3 : UCIP_FA_2023_78583_96924.jpg

WS view: Slope from crown, no pipe visible.

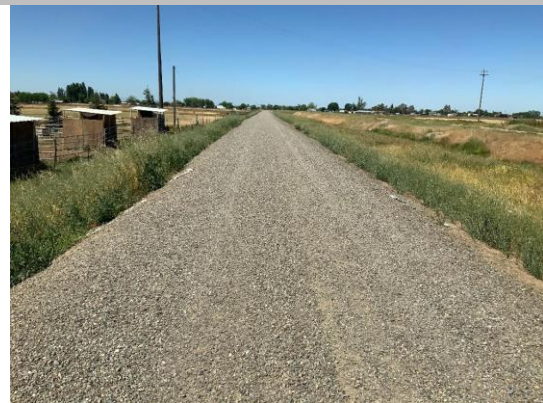
Photo 1 of 3 : UCIP_FA_2023_79046_96928.jpg

DS_ID:23842
 FS_ID:79046
 EP_NO: N/A
 Repair Type: Non-Urgent
 EVAL Issue:
 Crossing Status: Found
 UCIP Comments: 12/20/2022 Record updated from Urgent to Non-Urgent. Pipe has been CIPP lined. LOF of crossing is less or equal to 4. Recommend next video inspection in 5 years. (O.Yakimov - DWR UCIP)
 04/27/2021 The record has been upgraded from No Action Needed to Urgent. DWR DMP internal inspection has found pipe integrity issues. LOF of crossing is between 5 and 6. Crossing will be monitored until funding becomes available to address the issues. No permit was found authorizing this encroachment. CVFPB will need to review crossing to determine owner. The UCIP inspection was completed with LMA representative, J. Nelson. (H. Dunn – GEI)
 FIELD_STRUCT_DESC: 12-inch CIPP-lined corrugated metal storm drainage pipe (CMP) through the levee, 6.0 feet below the crown. Flap gate on the waterside (WS) end. Cobble grouted outlet on the WS end.

Levee crown looking downstream.

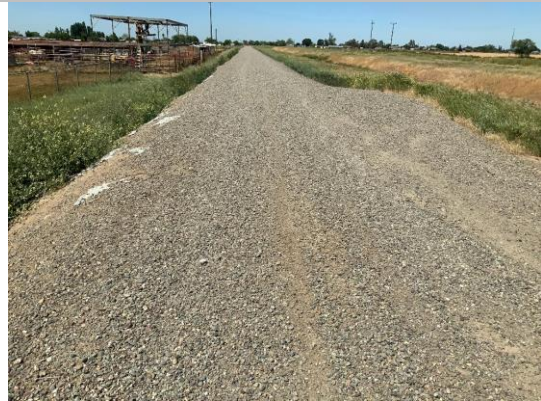
Photo 1 of 3 : UCIP_FA_2023_79047_96936.jpg

Comment Code					
Inspector Comment					
DS_ID:23843 FS_ID:79047 EP_NO: N/A Repair Type: Non-Urgent EVAL Issue: Crossing Status: Found UCIP Comments: 04/27/2021 The record has been upgraded from No Action Needed to Non-Urgent. DWR DMP internal inspection has not found pipe integrity issues. LOF of crossing is less or equal to 4.0. Recommend next inspection in 5 years. No permit was found authorizing this encroachment. CVFPB will need to review crossing to determine owner. The UCIP inspection was completed with LMA representative, J. Nelson. (H. Dunn – GEI) FIELD_STRUCT_DESC: 24-inch corrugated metal storm drainage pipe (CMP) through the levee, 4.5 feet below the crown. Flap gate on the waterside (WS) end. Concrete U-shaped headwalls on both ends. One corrugated metal cutoff wall. Cobble grouted outlet on the WS end. Cobble grouted intake on the landside (LS). [Additional Reference(s): DWR Levee Log, 1987, (HLM 1.09). USACE San Joaquin O&M Manual 612.2, 1967, (HLM 1.09), and 612 (addendum), February 1999, (HLM 1.09), (Station 57+30), 24-inch pipe listed]. FS Date: 4/27/2021

Levee crown looking downstream.

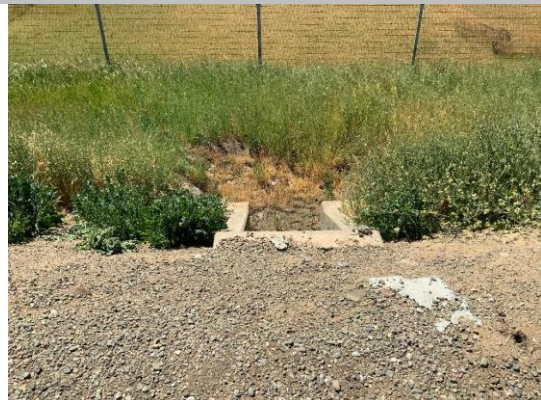
Photo 2 of 3 : UCIP_FA_2023_79047_96937.jpg

LS view: Headwall visible at toe from crown.

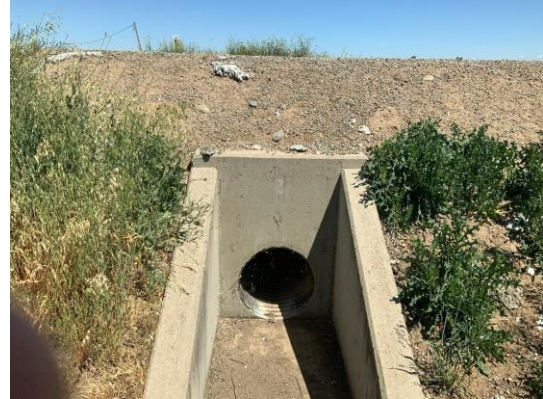
Photo 3 of 3 : UCIP_FA_2023_79047_96938.jpg

LS view: Slope and headwall at toe.

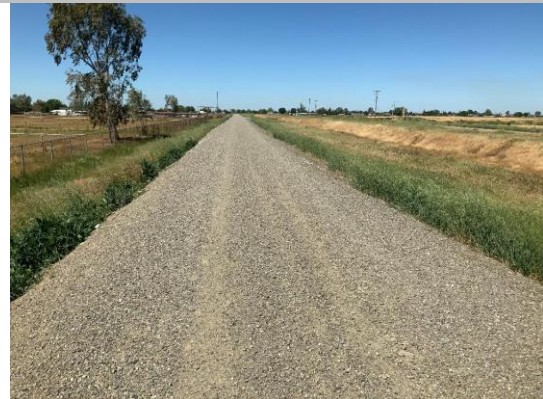
Photo 1 of 3 : UCIP_FA_2023_79048_96942.jpg

DS_ID:23844
 FS_ID:79048
 EP_NO: N/A
 Repair Type: Urgent
 EVAL Issue: 1, Pipe Integrity
 Crossing Status: Found
 UCIP Comments: 04/27/2021 The record has been upgraded from No Action Needed to Urgent. DWR DMP internal inspection has found pipe integrity issues. LOF of crossing is between 5 and 6. Crossing will be monitored until funding becomes available to address the issues. No permit was found authorizing this encroachment. CVFPB will need to review crossing to determine owner. The UCIP inspection was completed with LMA representative, J. Nelson. (H. Dunn – GEI)
 FIELD_STRUCT_DESC: 12-inch corrugated metal storm drainage pipe (CMP) through the levee, 7.0 feet below the crown. Flap gate on the waterside (WS) end. Headwall on the landside (LS) toe. Cobble grouted outlet on the WS end. [Additional Reference(s): DWR Levee Log, 1987, (HLM 1.18). USACE San Joaquin O&M Manual 612.2, 1967, (HLM 1.18), and 612 (addendum), February 1999, (HLM 1.17), (Station 61+82), 12-inch pipe listed].

Levee crown looking downstream.

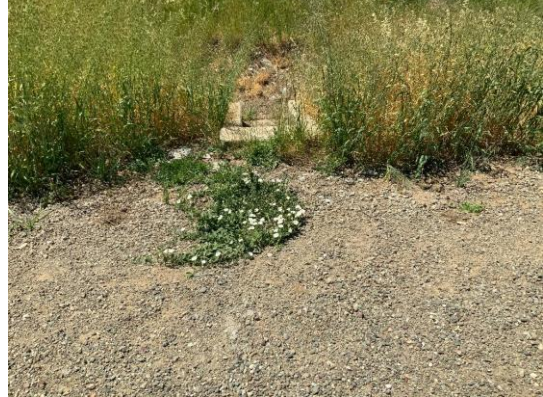
Photo 2 of 3 : UCIP_FA_2023_79048_96944.jpg

LS view: Headwall visible at toe from crown.

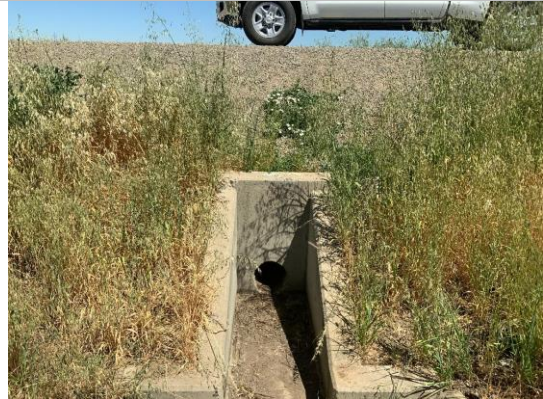
Photo 3 of 3 : UCIP_FA_2023_79048_96945.jpg

LS view: Slope and headwall at toe.

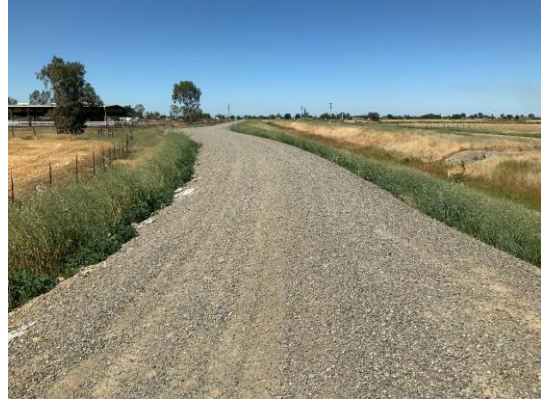
Photo 1 of 3 : UCIP_FA_2023_79049_96949.jpg

Comment Code						
Inspector Comment						
DS_ID:23845 FS_ID:79049 EP_NO: N/A Repair Type: Non-Urgent EVAL Issue: Crossing Status: Found UCIP Comments: 04/27/2021 The record has been upgraded from No Action Needed to Non-Urgent. DWR DMP internal inspection has not found pipe integrity issues. LOF of crossing is less or equal to 4.0. Recommend next inspection in 5 years. No permit was found authorizing this encroachment. CVFPB will need to review crossing to determine owner. The UCIP inspection was completed with LMA representative, J. Nelson. (H. Dunn – GEI) FIELD_STRUCT_DESC: 12-inch corrugated metal storm drainage pipe (CMP) through the levee, 6.5 feet below the crown. Flap gate on the waterside (WS) end. Cobble grouted outlet on the WS end. [Additional Reference(s): DWR Levee Log, 1987, (HLM 1.23). USACE San Joaquin O&M Manual 612.2, 1967, (HLM 1.23), and 612 (addendum), February 1999, (HLM 1.23), (Station 64+78), 12-inch pipe listed]. FS Date: 4/27/2021

Levee crown looking downstream.

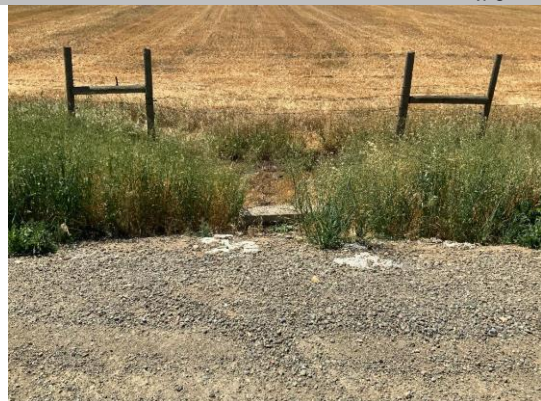
Photo 2 of 3 : UCIP_FA_2023_79049_96950.jpg

LS view: Headwall visible at toe from crown.

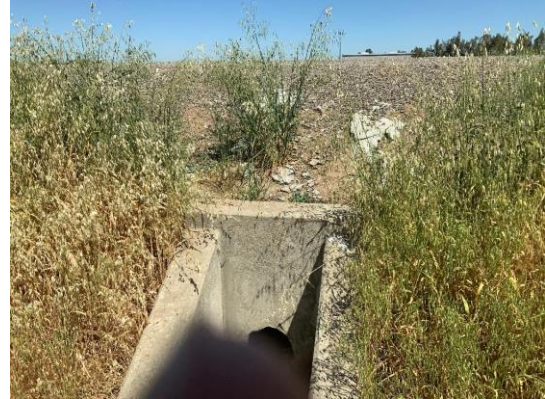
Photo 3 of 3 : UCIP_FA_2023_79049_96951.jpg

LS view: Slope and headwall at toe.

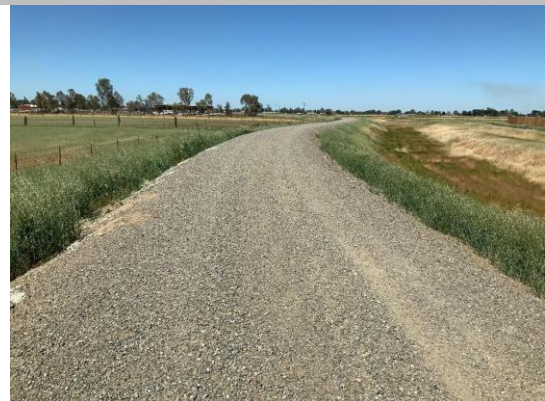
Photo 1 of 3 : UCIP_FA_2023_79050_96956.jpg

DS_ID:23846
 FS_ID:79050
 EP_NO: N/A
 Repair Type: No Action Needed
 EVAL Issue:
 Crossing Status: Found
 UCIP Comments: 04/27/2021 Record remains No Action Needed. DWR DMP internal inspection has not found pipe integrity issues. LOF of crossing is less or equal to 4.0. Recommend next inspection in 5 years. The UCIP inspection was completed with LMA representative, J. Nelson. (H. Dunn – GEI)
 FIELD_STRUCT_DESC: 12-inch corrugated metal storm drainage pipe (CMP) through the levee, 7.0 feet below the crown. Flap gate on the waterside (WS) end. Headwall on the landside (LS) toe. Cobble grouted outlet on the WS end. [Additional Reference(s): DWR Levee Log, 1987, (HLM 1.33). USACE San Joaquin O&M Manual 612.2, 1967, (HLM 1.33), and 612 (addendum), February 1999, (HLM 1.33), (Station 69+98), 12-inch pipe listed].
 FS Date: 4/27/2021

Levee crown looking downstream.

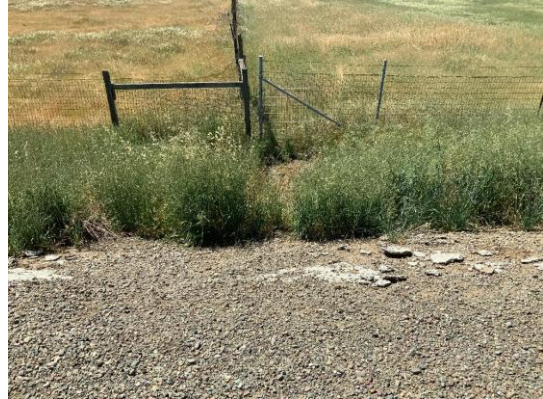
Photo 2 of 3 : UCIP_FA_2023_79050_96957.jpg

LS view: Toe from crown.

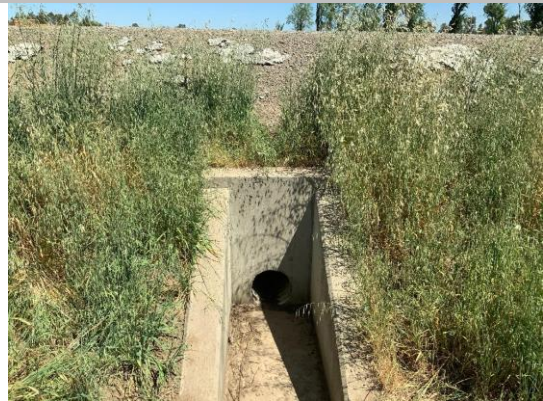
Photo 3 of 3 : UCIP_FA_2023_79050_96958.jpg

LS view: Slope and headwall at toe.

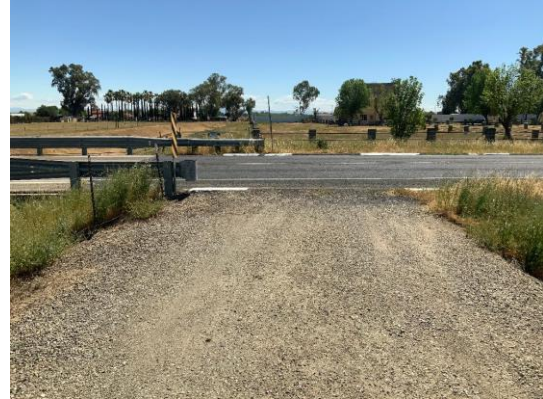
Photo 1 of 3 : UCIP_FA_2023_79051_96963.jpg

Comment Code						
Inspector Comment						
DS_ID:23847 FS_ID:79051 EP_NO: N/A Repair Type: Non-Urgent EVAL Issue: Crossing Status: Found UCIP Comments: 04/27/2021 Pipe status is still Non-Urgent. Barbed wire limiting closeup inspection of WS flapgate, but looked fine from afar. DWR DMP internal inspection has not found pipe integrity issues. LOF of crossing is less or equal to 4.0. Recommend next inspection in 5 years. No permit was found authorizing this encroachment. CVFPB will need to review crossing to determine owner. The UCIP inspection was completed with LMA representative, J. Nelson. (H. Dunn – GEI) 06/19/2014 Flapgate blocked by soil and possibly concrete on WS slope. (W. Wylie - DWR UCIP) FIELD_STRUCT_DESC: 21-inch corrugated metal storm drainage pipe (CMP) through the levee, 5.5 feet below the crown. Flap gate on the waterside (WS) end. Cobble grouted outlet on the WS end. [Additional Reference(s): DWR Levee Log, 1987, (HLM 1.45). USACE San Joaquin O&M Manual 612.2, 1967, (HLM 1.45), and 612 (addendum), February 1999, (HLM 1.45), (Station 76+42), 21-inch pipe listed]. FS Date: 4/27/2021

Levee crown looking upstream.

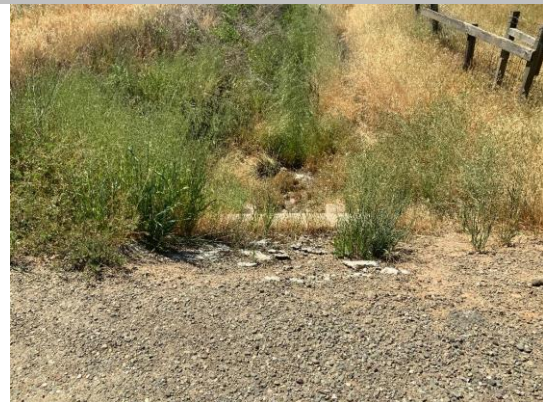
Photo 2 of 3 : UCIP_FA_2023_79051_96966.jpg

LS view: Headwall visible at toe from crown.

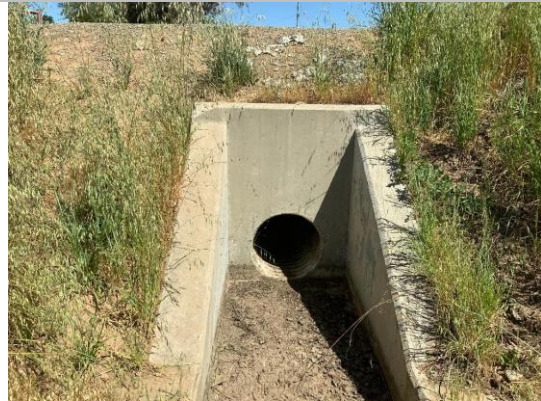
Photo 3 of 3 : UCIP_FA_2023_79051_96961.jpg

LS view: Slope and headwall at toe.

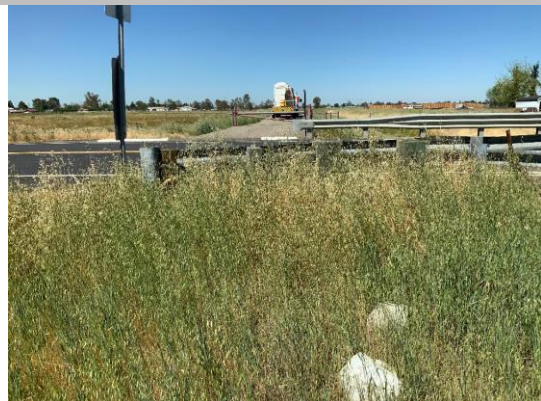
Photo 1 of 3 : UCIP_FA_2023_79052_96969.jpg

DS_ID:23848
 FS_ID:79052
 EP_NO: N/A
 Repair Type: Non-Urgent
 EVAL Issue: 5, Pipe Damage
 Crossing Status: Found
 UCIP Comments: 04/27/2021 The record has been upgraded from No Action Needed to Non-Urgent. DWR DMP internal inspection has found pipe integrity issues. LOF of crossing is between 4.1 and 5. Crossing will be monitored until funding becomes available for rehabilitation. WS pipe edges midly warped. No permit was found authorizing this encroachment. CVFPB will need to review crossing to determine owner. The UCIP inspection was completed with LMA representative, J. Nelson. (H. Dunn – GEI)
 FIELD_STRUCT_DESC: 21-inch corrugated metal storm drainage pipe (CMP) through the levee, 4.0 feet below the crown. Flap gate on the waterside (WS) end. Cobble grouted outlet on the WS end. [Additional Reference(s): DWR Levee Log, 1987, (HLM 1.47). USACE San Joaquin O&M Manual 612.2, 1967, (HLM 1.47), 21-inch pipe listed].

Levee crown looking downstream.

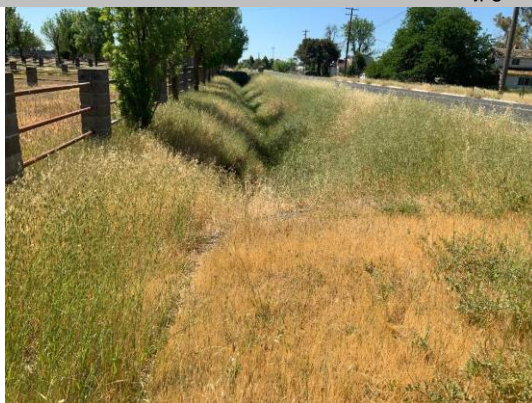
Photo 2 of 3 : UCIP_FA_2023_79052_96970.jpg

LS view: Toe from crown.
