**Flood Control Project Maintenance
Levee Inspections**

Maintenance Issue Types Only, Levee Inspection Report By Mile - Fall 2023

San Joaquin County Flood Control and Water Conservation District

Waterway	Bank	Unit Miles	Inspection Start/End	Inspector
Unit No. 01 Littlejohn Creek	Left	2.59	10/20/2023 10/20/2023	Alberto De Leon

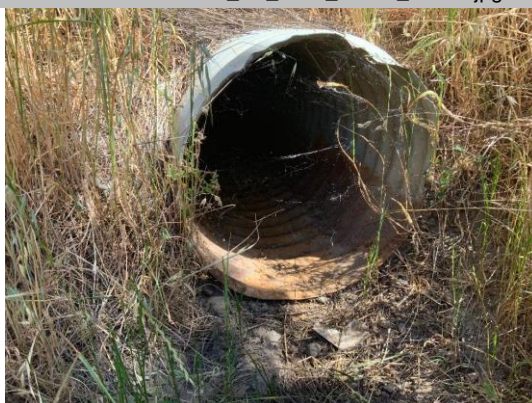
Photo 3 of 3 : UCIP_FA_2023_79052_96971.jpg

LS view: Close up of pipe inlet at toe, minor warping on edges.

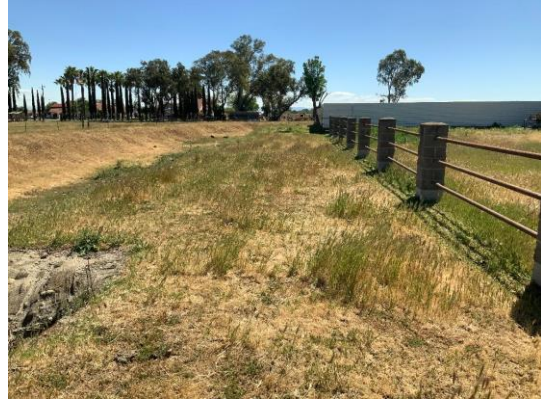
Photo 1 of 3 : UCIP_FA_2023_79053_96974.jpg

Comment Code						
Inspector Comment						
DS_ID:23849 FS_ID:79053 EP_NO: N/A Repair Type: Non-Urgent EVAL Issue: Crossing Status: Found UCIP Comments: 04/27/2021 The record has been upgraded from No Action Needed to Non-Urgent. No pipe on LS visible, appears to be buried and abandoned. Need confirmation from owner on status of pipe. No permit was found authorizing this encroachment. CVFPB will need to review crossing to determine owner. The UCIP inspection was completed with LMA representative, J. Nelson. (H. Dunn – GEI) 11/04/2016 Crossing has been downgraded to No Action Needed the vegetation and sediment has been cleared from the WS. Based on the current inspection this crossing does not appear to be abandoned. Need to coordinate with owner to determine status of crossing. (O. Magana - DWR UCIP) 06/19/2014 Flapgate blocked by sediment and vegetation on WS toe. Pipe outlet appears abandoned and if so should be done so properly. (W. Wylie - DWR UCIP) FIELD_STRUCT_DESC: 12-inch corrugated metal storm drainage pipe (CMP) through the levee, 2.0 feet below the crown. Flap gate on the waterside (WS) end. Cobble grouted outlet on the WS end. [Additional Reference(s): DWR Levee Log, 1977, 1978, 1987, 1990, (HLM 1.52). USACE San Joaquin O&M Manual 612.2, 1967, (HLM 1.52), Unit 7 (HLM 7.19–16.77), Unit 8 (HLM 7.55–16.48), Unit 9 (HLM 0.10–1.52), Unit 10 (HLM 0.03–1.35), Unit 11 (HLM 0.16–3.55), Unit 12 (HLM 0.14–3.91), Unit 13 (HLM 0.03–1.18), Unit 14 (HLM 0.02–1.17), 12-inch pipe listed]. FS Date: 4/27/2021

Levee crown looking upstream.

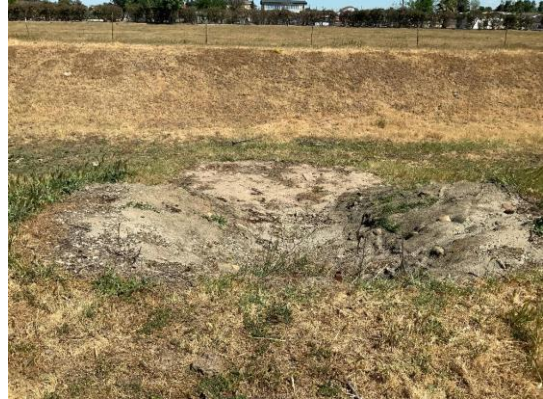
Photo 2 of 3 : UCIP_FA_2023_79053_96975.jpg

WS view: toe from crown.

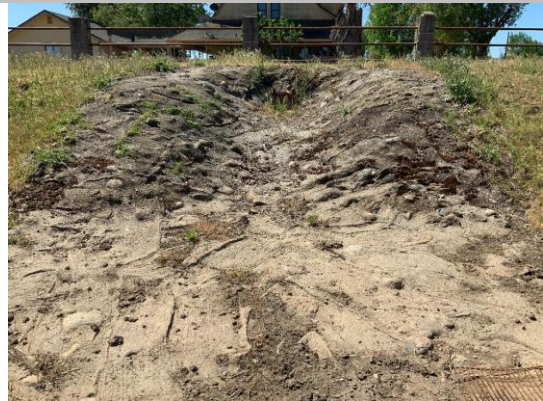
Photo 3 of 3 : UCIP_FA_2023_79053_96976.jpg

WS view: Slope and flapgate at toe.

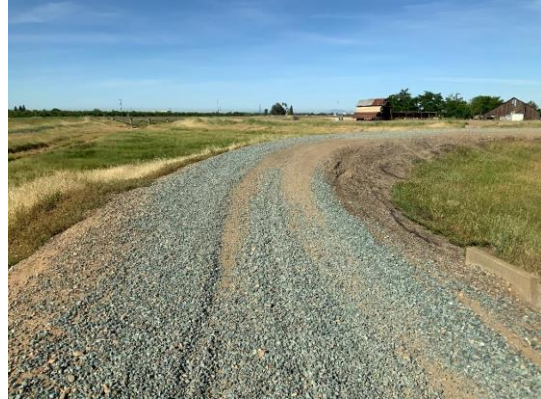
Photo 1 of 3 : UCIP_FA_2023_79054_97221.jpg

Comment Code					
Inspector Comment					
DS_ID:23859 FS_ID:79054 EP_NO: N/A Repair Type: Non-Urgent EVAL Issue: Crossing Status: Found UCIP Comments: 04/29/2021 The record has been upgraded from No Action Needed to Non-Urgent. DWR DMP internal inspection has not found pipe integrity issues. LOF of crossing is less or equal to 4.0. Recommend inspection in 5 years. No permit was found authorizing this encroachment. CVFPB will need to review crossing to determine owner. The UCIP inspection was completed with LMA representative, J. Nelson. (H. Dunn – GEI) FIELD_STRUCT_DESC: 36-inch corrugated metal storm drainage pipe (CMP) through the levee, 7.0 feet below the crown. Flap gate on the waterside (WS) end. Concrete U-shaped headwalls on both ends. Cobble grouted outlet on the WS end. Cobble grouted intake on the landside (LS). [Additional Reference(s): DWR Levee Log, 1978, (HLM 0.03). USACE San Joaquin O&M Manual 612.2, 1967, (HLM 0.03), 36-inch pipe listed]. FS Date: 4/29/2021

Levee crown looking downstream.

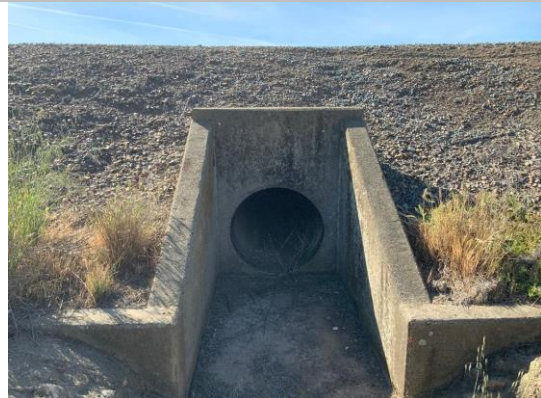
Photo 2 of 3 : UCIP_FA_2023_79054_97222.jpg

LS view: Slope and headwall at toe.

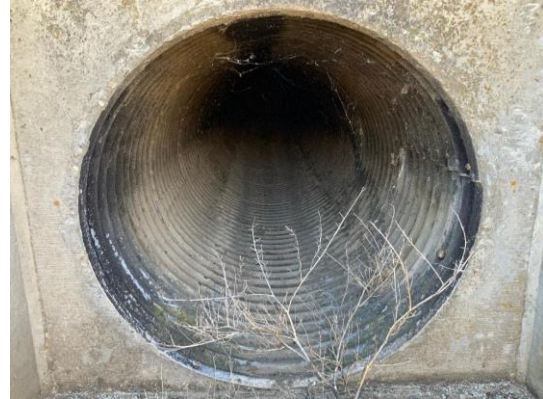
Photo 3 of 3 : UCIP_FA_2023_79054_97223.jpg

LS view: Close up of pipe inlet at toe.

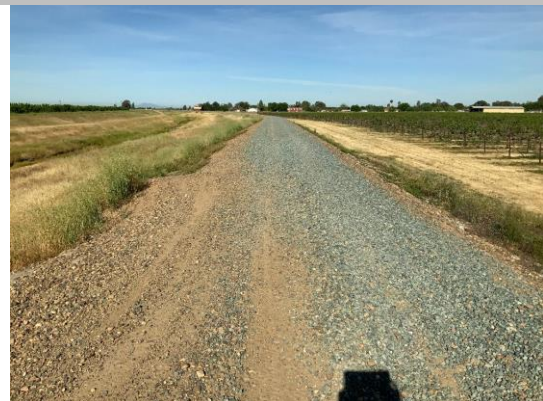
Photo 1 of 3 : UCIP_FA_2023_79055_97226.jpg

DS_ID:23860
 FS_ID:79055
 EP_NO: N/A
 Repair Type: Non-Urgent
 EVAL Issue:
 Crossing Status: Found
 UCIP Comments: 04/29/2021 The record has been upgraded from No Action Needed to Non-Urgent. DWR DMP internal inspection has not found pipe integrity issues. LOF of crossing is less or equal to 4.0. Recommend inspection in 5 years. No permit was found authorizing this encroachment. CVFPB will need to review crossing to determine owner. The UCIP inspection was completed with LMA representative, J. Nelson. (H. Dunn – GEI)
 FIELD_STRUCT_DESC: 24-inch corrugated metal storm drainage pipe (CMP) through the levee, 7.0 feet below the crown. Flap gate on the waterside (WS) end. Concrete U-shaped headwalls on both ends. Cobble grouted outlet on the WS end. Cobble grouted intake on the landside (LS). [Additional Reference(s): DWR Levee Log, 1978, (HLM 0.24). USACE San Joaquin O&M Manual 612.2, 1967, (HLM 0.24), 24-inch pipe listed].

Levee crown looking downstream.

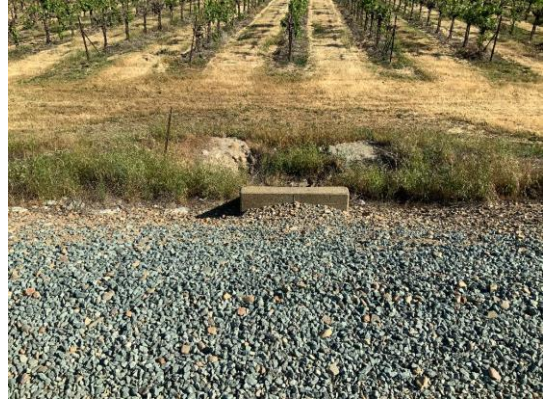
Photo 2 of 3 : UCIP_FA_2023_79055_97227.jpg

LS view: Headwall visible at toe from crown.

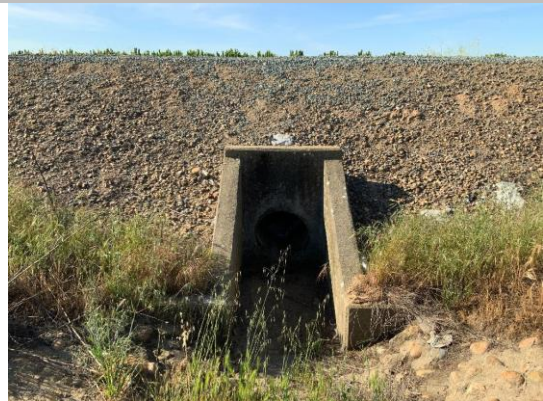
Photo 3 of 3 : UCIP_FA_2023_79055_97228.jpg

LS view: Slope and headwall at toe.

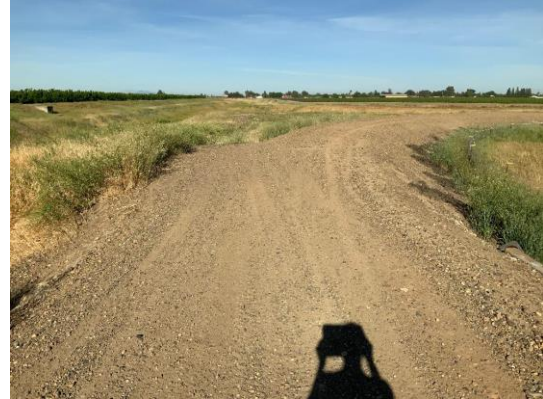
Photo 1 of 3 : UCIP_FA_2023_79056_97235.jpg

Comment Code						
Inspector Comment						
DS_ID:23861 FS_ID:79056 EP_NO: N/A Repair Type: Non-Urgent EVAL Issue: Crossing Status: Found UCIP Comments: 04/29/2021 The record has been upgraded from No Action Needed to Non-Urgent. DWR DMP internal inspection has not found pipe integrity issues. LOF of crossing is less or equal to 4.0. Recommend inspection in 5 years. No permit was found authorizing this encroachment. CVFPB will need to review crossing to determine owner. The UCIP inspection was completed with LMA representative, J. Nelson. (H. Dunn – GEI) FIELD_STRUCT_DESC: 24-inch corrugated metal storm drainage pipe (CMP) through the levee, 5.0 feet below the crown. Flap gate on the waterside (WS) end. Concrete U-shaped headwalls on both ends. Cobble grouted outlet on the WS end. Cobble grouted intake on the landside (LS). [Additional Reference(s): DWR Levee Log, 1978, (HLM 0.36). USACE San Joaquin O&M Manual 612.2, 1967, (HLM 0.36), 24-inch pipe listed]. FS Date: 4/29/2021

Levee crown looking downstream.

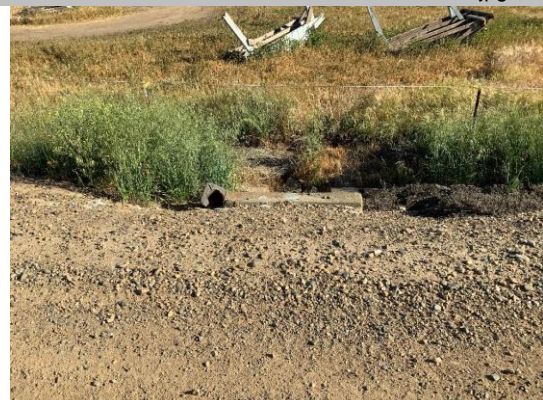
Photo 2 of 3 : UCIP_FA_2023_79056_97236.jpg

LS view: Headwall visible at toe from crown.

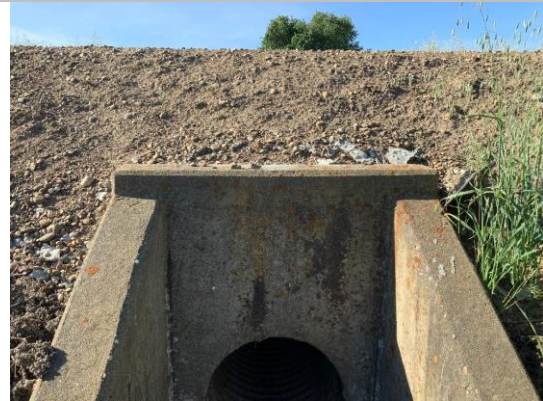
Photo 3 of 3 : UCIP_FA_2023_79056_97237.jpg

LS view: Slope and headwall at toe.

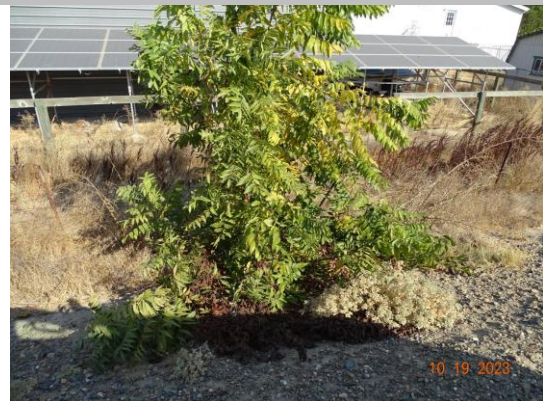
Photo 1 of 1 : FA_2023_NA0017_154_12_20231030_00035.jpg

LM Start	0.39	Rating **	M	Issue No.	12
LM End	0.39	Issue Type +	Ma	Location *	LS
Category	Earthen Levee			GPS Latitude/Longitude	
				Start	End
Item	Vegetation			38.095068°	38.095068°
				-121.167685°	-121.167685°
DWR ID	DWR_NA0017_10_s_2023_12				
Comment Code					
V2 : Remove the wild growth and woody vegetation other than native grasses from the levee slopes.					
Inspector Comment					
There are tree saplings along the landside slope.

View of tree saplings along the landside slope. Fall 2023

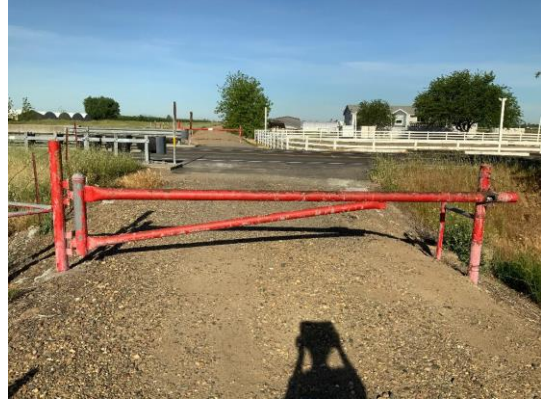
Photo 1 of 3 : UCIP_FA_2023_79057_97247.jpg

Comment Code					
Inspector Comment					
DS_ID:23863 FS_ID:79057 EP_NO: N/A Repair Type: Non-Urgent EVAL Issue: Crossing Status: Found UCIP Comments: 04/29/2021 The record has been upgraded from No Action Needed to Non-Urgent. DWR DMP internal inspection has not found pipe integrity issues. LOF of crossing is less or equal to 4.0. Something is peeling away inside the pipe inlet, possibly just the liner. No permit was found authorizing this encroachment. CVFPB will need to review crossing to determine owner. The UCIP inspection was completed with LMA representative, J. Nelson. (H. Dunn – GEI) FIELD_STRUCT_DESC: 24-inch corrugated metal storm drainage pipe (CMP) through the levee, 4.0 feet below the crown. Flap gate on the waterside (WS) end. Concrete U-shaped headwalls on both ends. Cobble grouted outlet on the WS end. Cobble grouted intake on the landside (LS). [Additional Reference(s): DWR Levee Log, 1978, (HLM 0.46). USACE San Joaquin O&M Manual 612.2, 1967, (HLM 0.46), 24-inch pipe listed]. FS Date: 4/29/2021

Levee crown looking downstream.

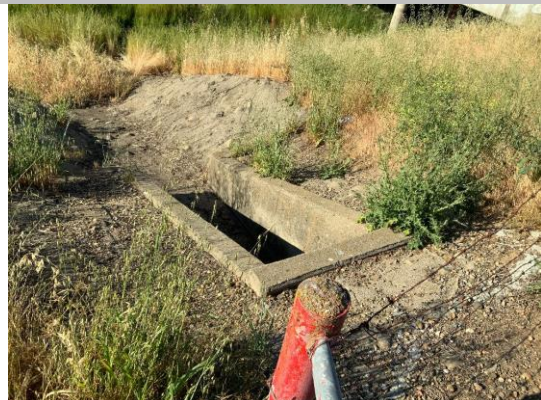
Photo 2 of 3 : UCIP_FA_2023_79057_97248.jpg

WS view: Headwall visible at toe from crown.

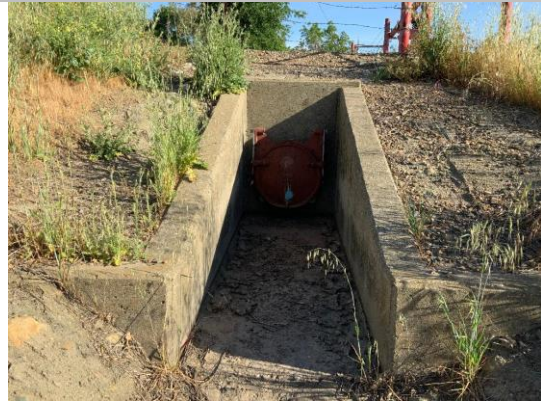
Photo 3 of 3 : UCIP_FA_2023_79057_97249.jpg

WS view: Slope, headwall, and flapgate at toe.

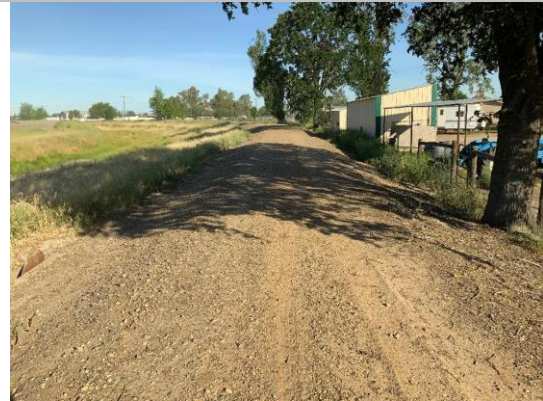
Photo 1 of 3 : UCIP_FA_2023_79058_97258.jpg

Comment Code						
Inspector Comment						
DS_ID:23864 FS_ID:79058 EP_NO: N/A Repair Type: Non-Urgent EVAL Issue: Crossing Status: Found UCIP Comments: 04/29/2021 The record has been upgraded from No Action Needed to Non-Urgent. DWR DMP internal inspection has not found pipe integrity issues. LOF of crossing is less or equal to 4.0. Recommend inspection in 5 years. No permit was found authorizing this encroachment. CVFPB will need to review crossing to determine owner. The UCIP inspection was completed with LMA representative, J. Nelson. (H. Dunn – GEI) FIELD_STRUCT_DESC: 24-inch corrugated metal storm drainage pipe (CMP) through the levee, 5.0 feet below the crown. Flap gate on the waterside (WS) end. Concrete U-shaped headwalls on both ends. Cobble grouted outlet on the WS end. Cobble grouted intake on the landside (LS). (3-inch polyvinyl chloride [PVC] pipe sleeved through 24-inch pipe authorized under Permit No. 11617, 1976 - Tom Patterson). [Additional Reference(s): DWR Levee Log, 1978, (HLM 0.58). USACE San Joaquin O&M Manual 612.2, 1967, (HLM 0.58), 24-inch pipe listed]. FS Date: 4/29/2021

Levee crown looking downstream.

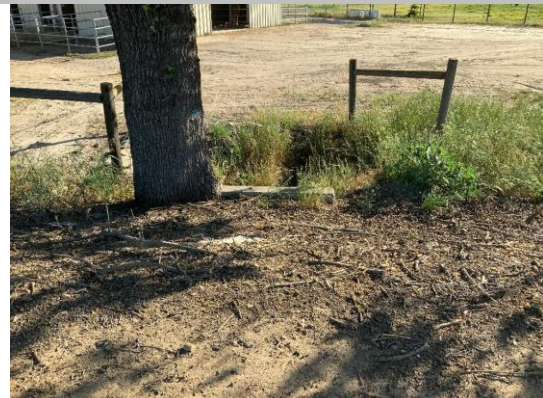
Photo 2 of 3 : UCIP_FA_2023_79058_97259.jpg

LS view: Headwall visible at toe from crown.

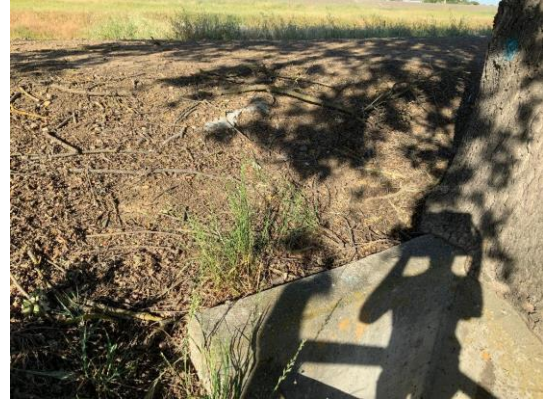
Photo 3 of 3 : UCIP_FA_2023_79058_97260.jpg

LS view: Slope above headwall from toe.

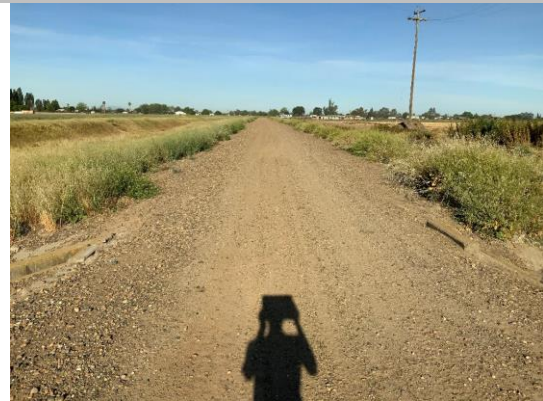
Photo 1 of 3 : UCIP_FA_2023_79059_97264.jpg

Levee crown looking downstream.

DS_ID:23865
 FS_ID:79059
 EP_NO: N/A
 Repair Type: Non-Urgent
 EVAL Issue:
 Crossing Status: Found
 UCIP Comments: 04/29/2021 The record has been upgraded from No Action Needed to Non-Urgent. DWR DMP internal inspection has not found pipe integrity issues. LOF of crossing is less or equal to 4.0. Recommend inspection in 5 years. No permit was found authorizing this encroachment. CVFPB will need to review crossing to determine owner. The UCIP inspection was completed with LMA representative, J. Nelson. (H. Dunn – GEI)
 FIELD_STRUCT_DESC: 24-inch corrugated metal storm drainage pipe (CMP) through the levee, 5.5 feet below the crown. Flap gate on the waterside (WS) end. Concrete U-shaped headwalls on both ends. Cobble grouted outlet on the WS end. Cobble grouted intake on the landside (LS). [Additional Reference(s): DWR Levee Log, 1978, (HLM 0.86). USACE San Joaquin O&M Manual 612.2, 1967, (HLM 0.86), 24-inch pipe listed].

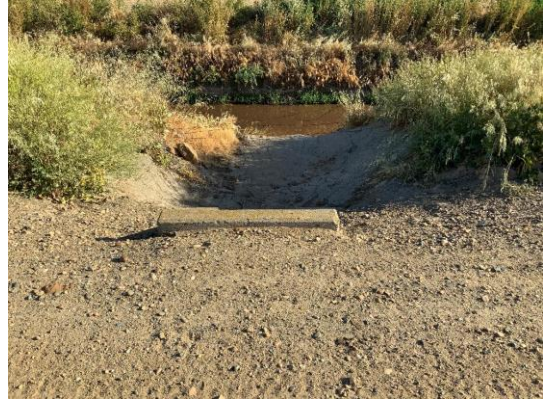
Photo 2 of 3 : UCIP_FA_2023_79059_97265.jpg

LS view: Headwall visible at toe from crown.

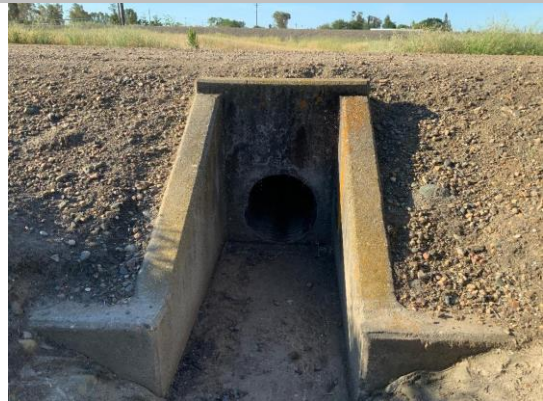
Photo 3 of 3 : UCIP_FA_2023_79059_97266.jpg

LS view: Slope and headwall at toe.

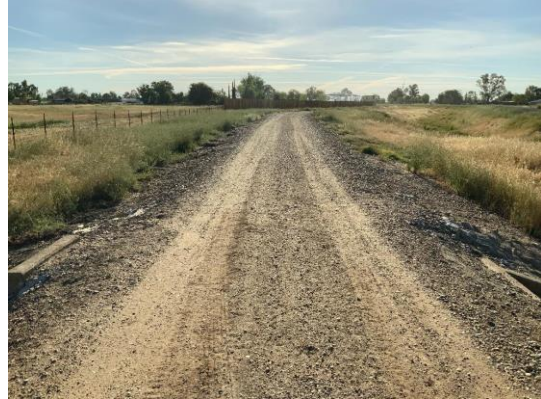
Photo 1 of 3 : UCIP_FA_2023_79060_97270.jpg

Comment Code						
Inspector Comment						
DS_ID:23866						
FS_ID:79060						
EP_NO: N/A						
Repair Type: Non-Urgent						
EVAL Issue:						
Crossing Status: Found						
UCIP Comments: 04/29/2021 The record has been upgraded from No Action Needed to Non-Urgent. DWR DMP internal inspection has not found pipe integrity issues. LOF of crossing is less or equal to 4.0. Recommend inspection in 5 years. No permit was found authorizing this encroachment. CVFPB will need to review crossing to determine owner. The UCIP inspection was completed with LMA representative, J. Nelson. (H. Dunn – GEI)						
FIELD_STRUCT_DESC: 24-inch corrugated metal storm drainage pipe (CMP) through the levee, 5.0 feet below the crown. Flap gate on the waterside (WS) end. Concrete U-shaped headwalls on both ends. Cobble grouted outlet on the WS end. Cobble grouted intake on the landside (LS). [Additional Reference(s): DWR Levee Log, 1978, (HLM 1.09). USACE San Joaquin O&M Manual 612.2, 1967, (HLM 1.09), 24-inch pipe listed].

Levee crown looking upstream.

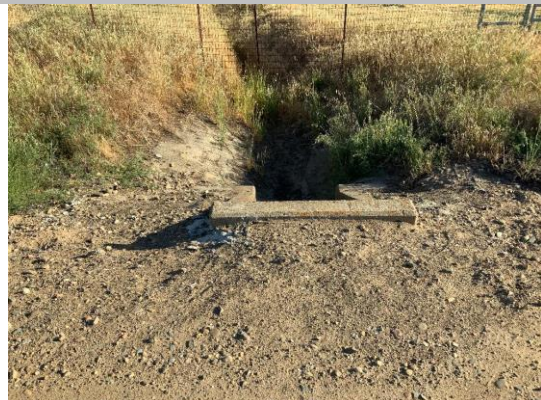
Photo 2 of 3 : UCIP_FA_2023_79060_97271.jpg

LS view: Headwall visible at toe from crown.

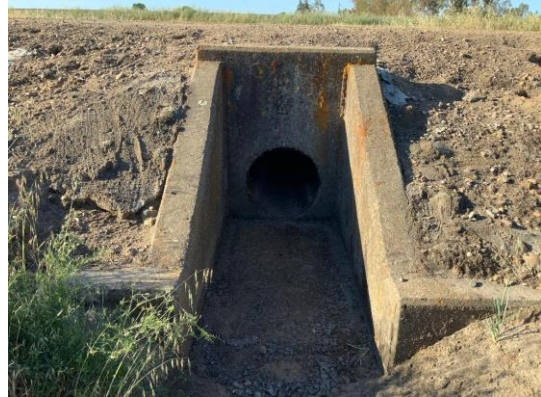
Photo 3 of 3 : UCIP_FA_2023_79060_97272.jpg

LS view: Slope and headwall at toe.

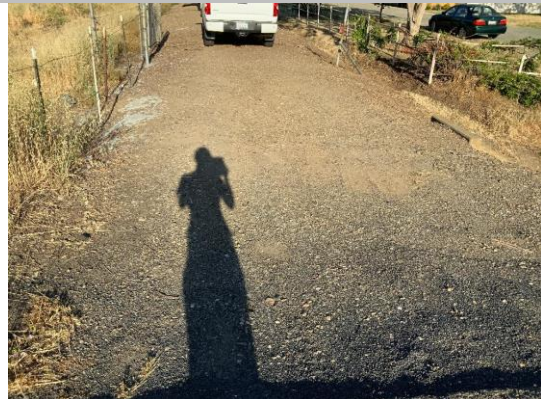
Photo 1 of 3 : UCIP_FA_2023_79061_97278.jpg

DS_ID:23867
 FS_ID:79061
 EP_NO: N/A
 Repair Type: Non-Urgent
 EVAL Issue:
 Crossing Status: Found
 UCIP Comments: 04/29/2021 The record has been upgraded from No Action Needed to Non-Urgent. DWR DMP internal inspection has not found pipe integrity issues. LOF of crossing is less or equal to 4.0. Recommend inspection in 5 years. No permit was found authorizing this encroachment. CVFPB will need to review crossing to determine owner. The UCIP inspection was completed with LMA representative, J. Nelson. (H. Dunn – GEI)
 FIELD_STRUCT_DESC: 24-inch corrugated metal storm drainage pipe (CMP) through the levee, 4.0 feet below the crown. Flap gate on the waterside (WS) end. Concrete U-shaped headwalls on both ends. Cobble grouted outlet on the WS end. Cobble grouted intake on the landside (LS). [Additional Reference(s): DWR Levee Log, 1978, (HLM 1.33). USACE San Joaquin O&M Manual 612.2, 1967, (HLM 1.33), 24-inch pipe listed].

Levee crown looking downstream.

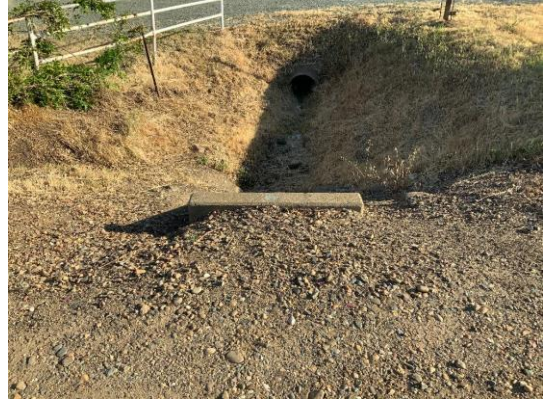
Photo 2 of 3 : UCIP_FA_2023_79061_97279.jpg

LS view: Headwall visible at toe from crown.

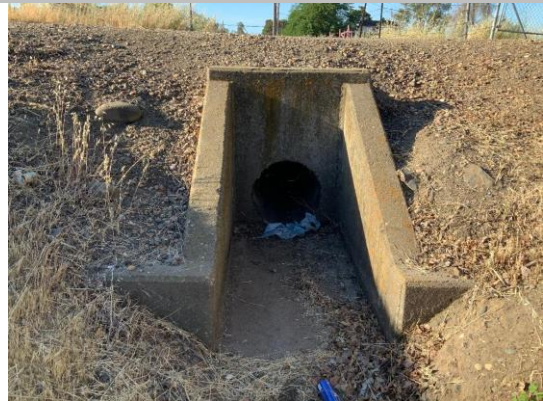
Photo 3 of 3 : UCIP_FA_2023_79061_97280.jpg

LS view: Slope and headwall at toe.

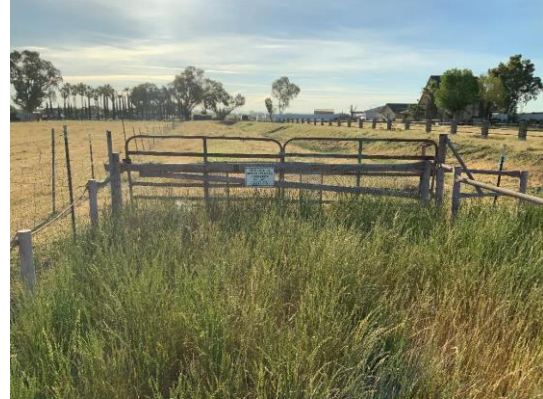
Photo 1 of 3 : UCIP_FA_2023_79418_97285.jpg

Comment Code						
Inspector Comment						
DS_ID:23868 FS_ID:79418 EP_NO: N/A Repair Type: Non-Urgent EVAL Issue: 5, Pipe Damage Crossing Status: Found UCIP Comments: 03/31/2023 Record updated from Urgent to Non-Urgent. LoF is equal to 5.1 due to a small hole near landside pipe end, other integrity issues were not found. Crossing will be monitored until funding becomes available for rehabilitation. (O.Yakimov - DWR UCIP). 04/29/2021 Record has been upgraded from No Action Needed to Urgent. DWR DMP internal inspection has found pipe integrity issues. LOF of crossing is between 5 and 6. Crossing will be monitored until funding becomes available to address the issues. No permit was found authorizing this encroachment. CVFPB will need to review crossing to determine owner. The UCIP inspection was completed with LMA representative, J. Nelson. (H. Dunn ? GEI)04/28/2017 Crossing has been downgraded from Non-Urgent to No Action Needed, since sediment buildup is only minimal. (K. Fazel - UCIP)06/19/2014 Some sediment buildup in pipe at LS toe. (G. Wylie - FPIIB) FIELD_STRUCT_DESC: 30-inch corrugated metal storm drainage pipe (CMP) through the levee, 6.0 feet below the crown. Flap gate on the waterside (WS) end. Cobble grouted outlet on the WS end. Cobble grouted intake on the landside (LS). [Additional Reference(s): DWR Levee Log, 1978, (HLM 1.35). USACE San Joaquin O&M Manual 612.2, 1967, (HLM 1.35), 30-inch pipe listed]. FS Date: 4/29/2021

Levee crown looking downstream.

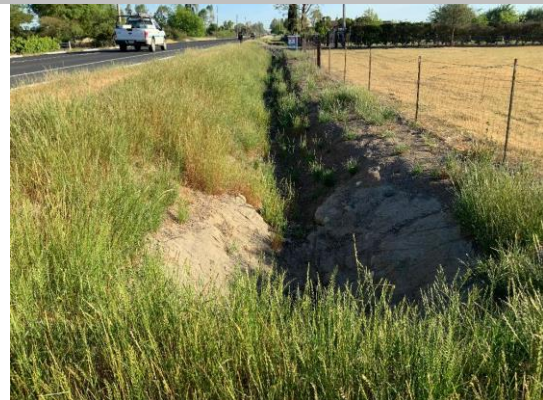
Photo 2 of 3 : UCIP_FA_2023_79418_97286.jpg

LS view: Slope from crown.

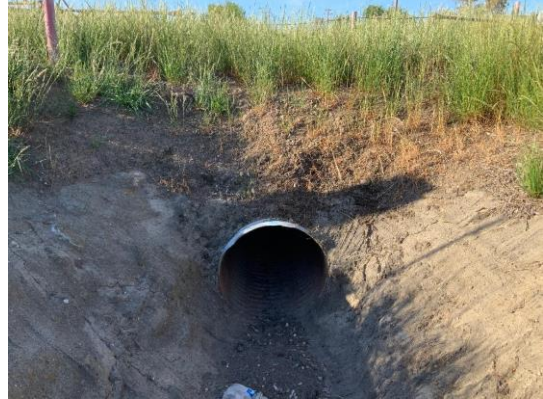
Photo 3 of 3 : UCIP_FA_2023_79418_97287.jpg

LS view: Slope and pipe inlet at toe.

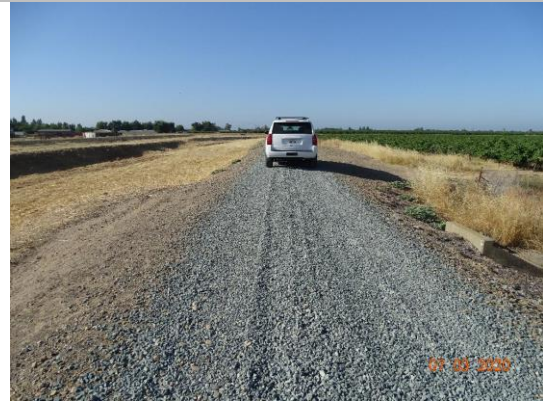
Photo 1 of 3 : UCIP_FA_2023_79064_86887.jpg

Comment Code					
Inspector Comment					
DS_ID:23880 FS_ID:79064 EP_NO: N/A Repair Type: Non-Urgent EVAL Issue: Crossing Status: Found UCIP Comments: 07/03/2020 Crossing evaluated as "Non-Urgent" because there was no permit found authorizing this pipe. (A. McDonald - DWR UCIP) FIELD_STRUCT_DESC: 24-inch corrugated metal drainage pipe through the levee, 5 feet below the crown. Concrete U-shaped headwall on both ends. Flap gate on the waterside (WS) end. Cobble grouted outlet. Cobble grouted intake on the landside (LS). [Additional Reference(s): DWR Levee Log, 1978, (HLM 0.16). USACE San Joaquin O&M Manual 612.2, 1967, (HLM 0.16), 24-inch pipe listed]. FS Date: 7/3/2020

Overview of levee crown looking d/s.

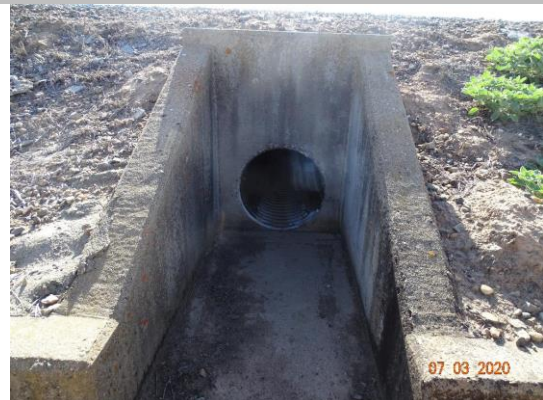
Photo 2 of 3 : UCIP_FA_2023_79064_86888.jpg

Pipe inlet and headwall at LS levee toe.

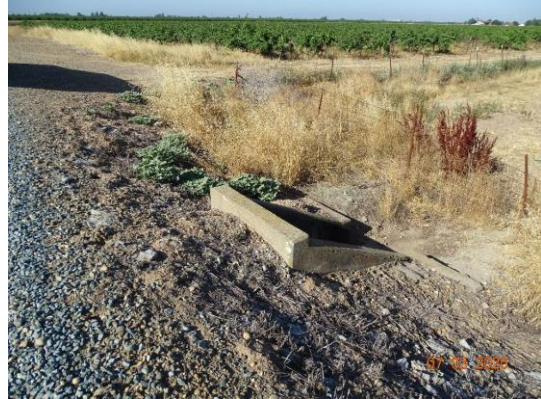
Photo 3 of 3 : UCIP_FA_2023_79064_86889.jpg

Pipe inlet, headwall, and flap gate at LS levee toe.

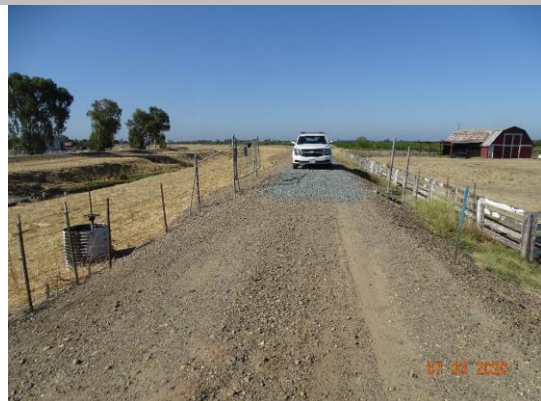
Photo 1 of 3 : UCIP_FA_2023_79065_86893.jpg

DS_ID:23881
 FS_ID:79065
 EP_NO: N/A
 Repair Type: No Action Needed
 EVAL Issue:
 Crossing Status: Found
 UCIP Comments: 07/03/2020 Record remains No Action Needed. No issues observed during inspection. (A. McDonald - DWR UCIP)
 06/12/2014 Slide gate does not function properly up or down. (DWR UCIP)
 FIELD_STRUCT_DESC: 24-inch corrugated metal drainage pipe through the levee, 11 feet below the crown. Slide gate in 36-inch corrugated metal riser unit on the waterside (WS). Concrete U-shaped headwall on the WS end. Cobble grouted outlet. Cobble grouted intake on the landside (LS). [Additional Reference(s): DWR Levee Log, 1978, (HLM 0.47). USACE San Joaquin O&M Manual 612.2, 1967, (HLM 0.47), 24-inch pipe listed].
 FS Date: 7/3/2020

Overview of levee crown looking d/s.

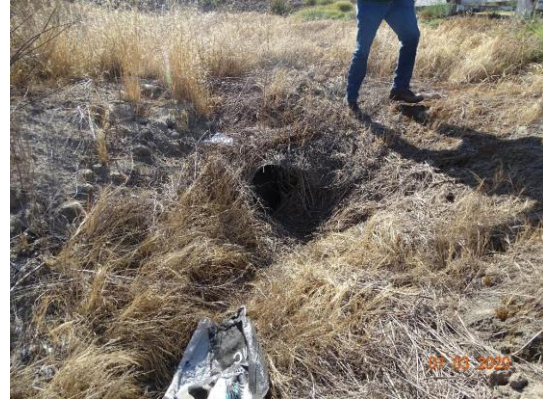
Photo 2 of 3 : UCIP_FA_2023_79065_86894.jpg

Pipe inlet at the LS levee toe. No headwall.

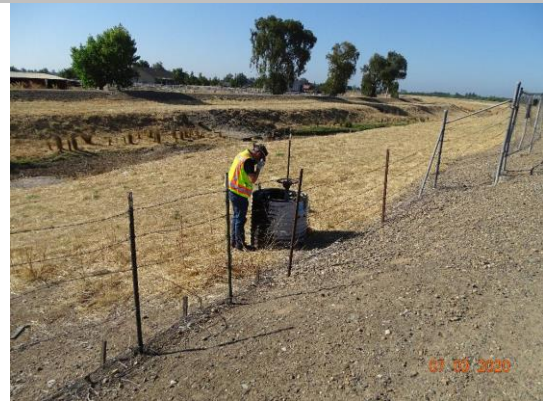
Photo 3 of 3 : UCIP_FA_2023_79065_86895.jpg

Riser and slide gate at the WS levee toe.

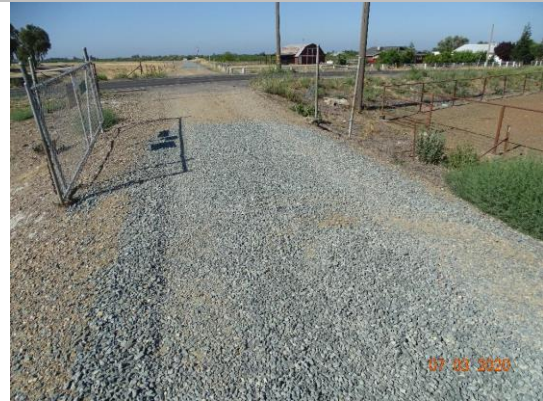
Photo 1 of 3 : UCIP_FA_2023_79066_86906.jpg

Comment Code						
Inspector Comment						
DS_ID:23882 FS_ID:79066 EP_NO: N/A Repair Type: Non-Urgent EVAL Issue: 5, Pipe Damage Crossing Status: Found UCIP Comments: 07/03/2020 Crossing evaluated as "Non-Urgent" because there was no permit found authorizing this pipe. Video inspection performed on 02/21/2020. (A. McDonald - DWR UCIP) FIELD_STRUCT_DESC: 24-inch corrugated metal drainage pipe through the levee, 7 feet below the crown. Concrete U-shaped headwall on both ends. Flap gate on the waterside (WS) end. Cobble grouted outlet. Cobble grouted intake on the landside (LS). [Additional Reference(s): DWR Levee Log, 1978, (HLM 0.50). USACE San Joaquin O&M Manual 612.2, 1967, (HLM 0.50), 24-inch pipe listed]. FS Date: 7/3/2020

Overview of levee crown looking d/s.

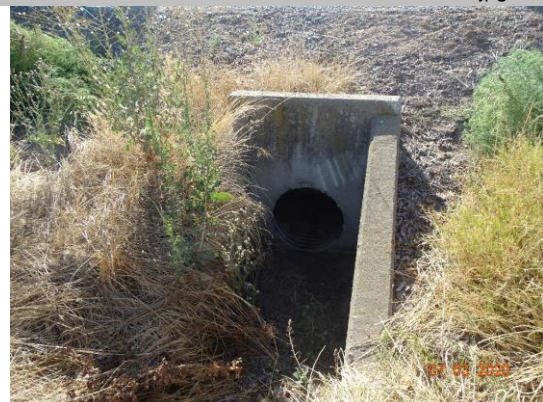
Photo 2 of 3 : UCIP_FA_2023_79066_86907.jpg

Pipe inlet and headwall at the LS levee toe.

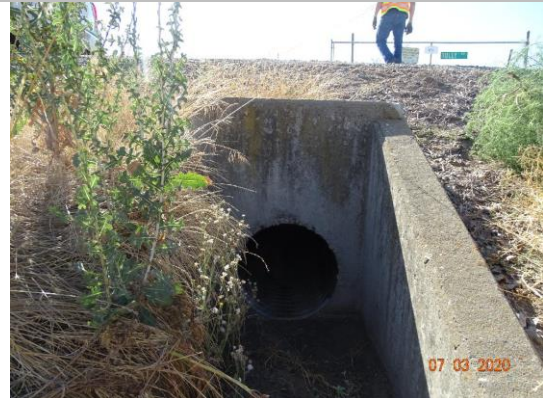
Photo 3 of 3 : UCIP_FA_2023_79066_86908.jpg

Pipe inlet and headwall at the LS levee toe.

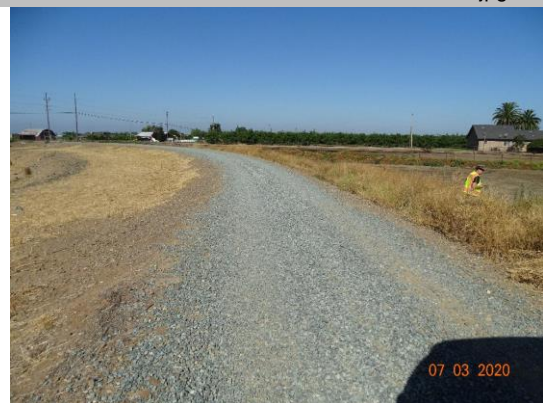
Photo 1 of 3 : UCIP_FA_2023_79067_86911.jpg

DS_ID:23883
 FS_ID:79067
 EP_NO: N/A
 Repair Type: Non-Urgent
 EVAL Issue:
 Crossing Status: Found
 UCIP Comments: 07/03/2020 Crossing evaluated as "Non-Urgent" because there was no permit found authorizing this pipe. Video inspection performed on 02-21-2020. (A. McDonald - DWR UCIP) 06/12/2014 Pipe filled in with soil on the LS toe and appears to be temporarily abandoned. (DWR UCIP)
 FIELD_STRUCT_DESC: 24-inch corrugated metal drainage pipe through the levee, 6.5 feet below the crown. Concrete U-shaped headwall on both ends. Flap gate on the waterside (WS) end. Cobble grouted outlet. Cobble grouted intake on the landside (LS). [Additional Reference(s): DWR Levee Log, 1978, (HLM 0.55). USACE San Joaquin O&M Manual 612.2, 1967, (HLM 0.55), 24-inch pipe listed].
 FS Date: 7/3/2020

Overview of levee crown looking d/s.

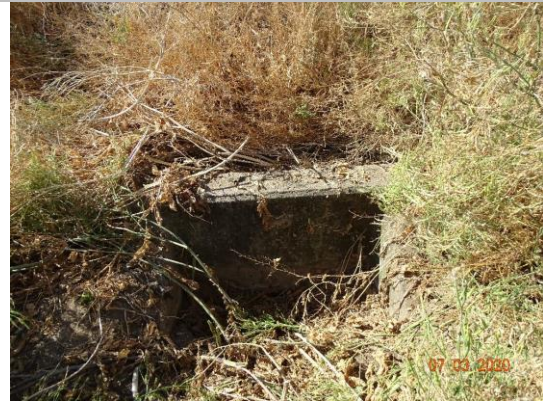
Photo 2 of 3 : UCIP_FA_2023_79067_86912.jpg

Pipe inlet and headwall at the LS levee toe.

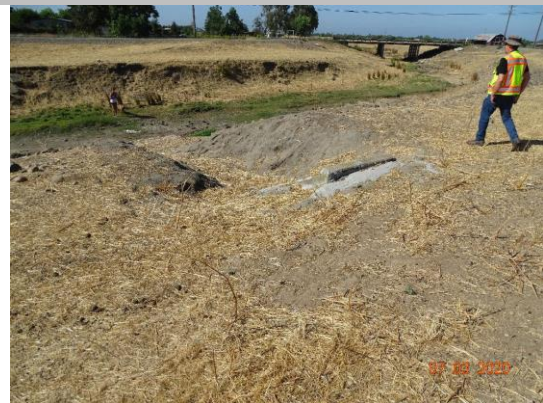
Photo 3 of 3 : UCIP_FA_2023_79067_86913.jpg

Pipe outlet, headwall, and flap gate at the WS levee toe.

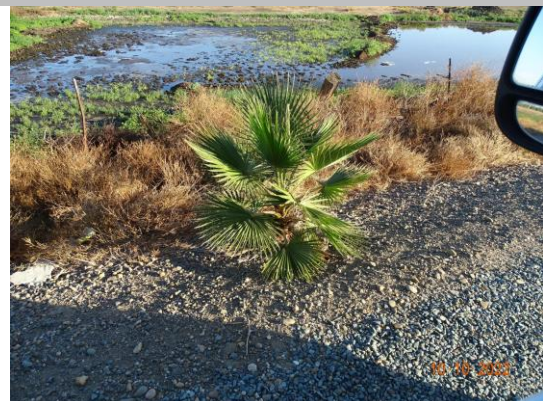
Photo 1 of 1 : FA_2023_NA0017_155_35_20230905_00005.jpg

LM Start	0.56	Rating **	M	Issue No.	35
LM End	0.56	Issue Type +	Ma	Location *	LS
Category	Earthen Levee			GPS Latitude/Longitude	
				Start	End
Item	Vegetation			38.102512°	38.102512°
				-121.167613°	-121.167613°
DWR ID	DWR_NA0017_11_f_2022_35				
Comment Code					
V2 : Remove the wild growth and woody vegetation other than native grasses from the levee slopes.					
Inspector Comment					
There is a palm tree growing on the landside slope.

View of palm tree growing on the landside slope. Fall 2022

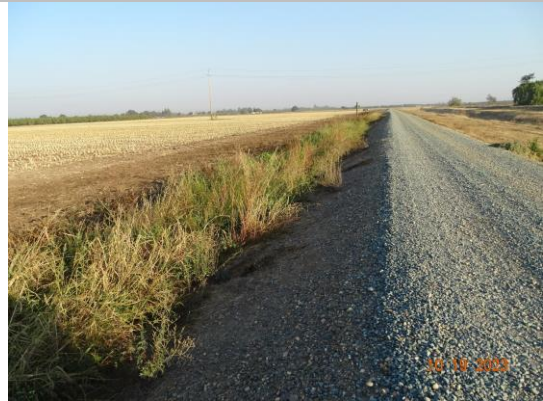
Photo 1 of 1 : FA_2023_NA0017_155_27_20231030_00079.jpg

LM Start	0.73	Rating **	U	Issue No.	27
LM End	0.82	Issue Type +	Ma	Location *	LS
Category	Earthen Levee			GPS Latitude/Longitude	
				Start	End
Item	Vegetation			38.104373°	38.105649°
				-121.166264°	-121.166262°
DWR ID	DWR_NA0017_11_f_2023_27				
Comment Code					
V1 : Control annual grass and weeds on the levee slopes and easements.					
Inspector Comment

View of vegetation blocking visibility on the landside slope and easement. Fall 2023

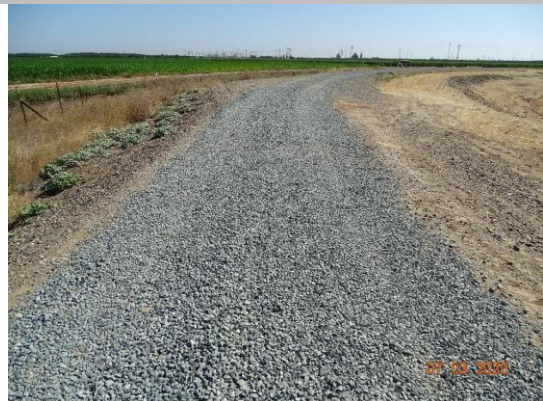
Photo 1 of 3 : UCIP_FA_2023_79068_86934.jpg

Comment Code						
Inspector Comment						
DS_ID:23885 FS_ID:79068 EP_NO: N/A Repair Type: Non-Urgent EVAL Issue: Crossing Status: Found UCIP Comments: 07/03/2020 Crossing evaluated as "Non-Urgent" because there was no permit found authorizing this pipe. Video inspection performed on 04-24-2020. (A. McDonald - DWR UCIP) FIELD_STRUCT_DESC: 24-inch corrugated metal drainage pipe through the levee, 6 feet below the crown. Concrete U-shaped headwall on both ends. Flap gate on the waterside (WS) end. Slide gate on the landside (LS) end. Cobble grouted outlet. Cobble grouted intake on the LS. [Additional Reference(s): DWR Levee Log, 1978, (HLM 1.07). USACE San Joaquin O&M Manual 612.2, 1967, (HLM 1.07), 24-inch pipe listed]. FS Date: 7/3/2020

Overview of levee crown looking d/s.

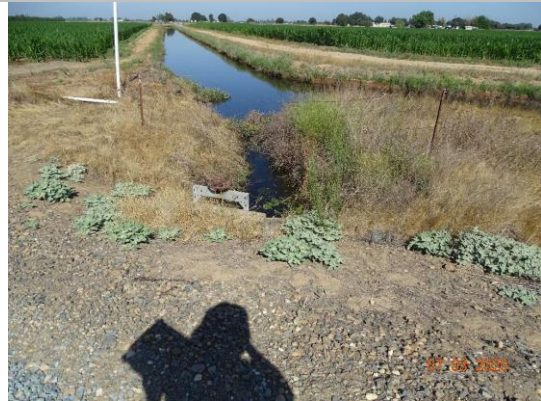
Photo 2 of 3 : UCIP_FA_2023_79068_86930.jpg

View of pipe inlet, headwall, and slide gate at the LS levee toe.

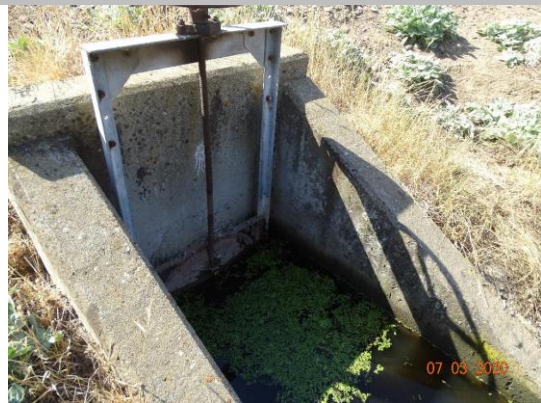
Photo 3 of 3 : UCIP_FA_2023_79068_86931.jpg

Pipe inlet, headwall, and slide gate at the LS levee toe.

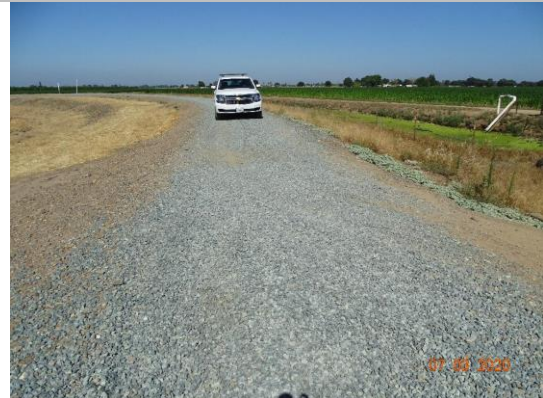
Photo 1 of 3 : UCIP_FA_2023_79069_86936.jpg

Comment Code						
Inspector Comment						
DS_ID:23870 FS_ID:79069 EP_NO: N/A Repair Type: Non-Urgent EVAL Issue: Crossing Status: Found UCIP Comments: 07/03/2020 Crossing evaluated as "Non-Urgent" because there was no permit found authorizing this pipe. (A. McDonald - DWR UCIP) FIELD_STRUCT_DESC: 24-inch corrugated metal drainage pipe through the levee, 8 feet below the crown. Concrete U-shaped headwall on both ends. Flap gate on the waterside (WS) end. Slide gate on the landside (LS) end. Two corrugated metal cutoff walls. Cobble grouted outlet. Cobble grouted intake on the LS. [Additional Reference(s): DWR Levee Log, 1978, (HLM 1.15). USACE San Joaquin O&M Manual 612.2, 1967, (HLM 1.15), 24-inch pipe listed]. FS Date: 7/3/2020

Overview of levee crown looking d/s.

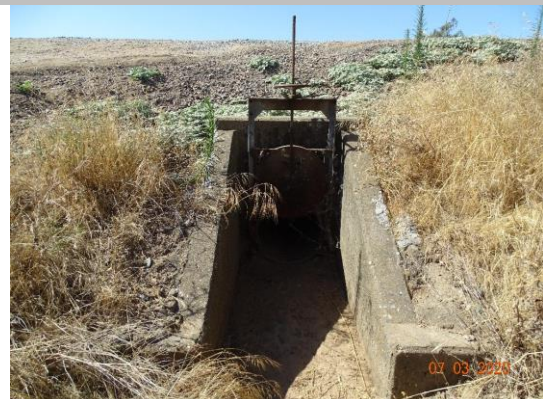
Photo 2 of 3 : UCIP_FA_2023_79069_86937.jpg

Pipe inlet, headwall, and slide gate at the LS levee toe.

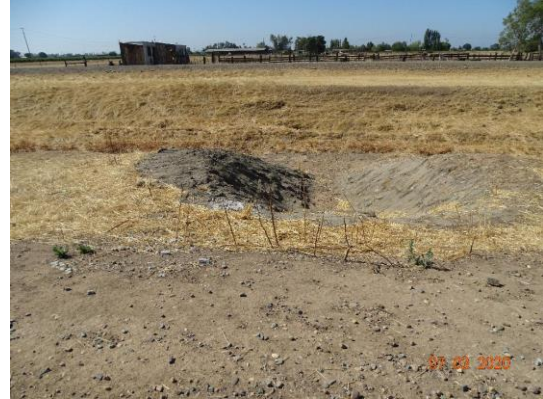
Photo 3 of 3 : UCIP_FA_2023_79069_86938.jpg

View of WS channel looking from the levee crown.

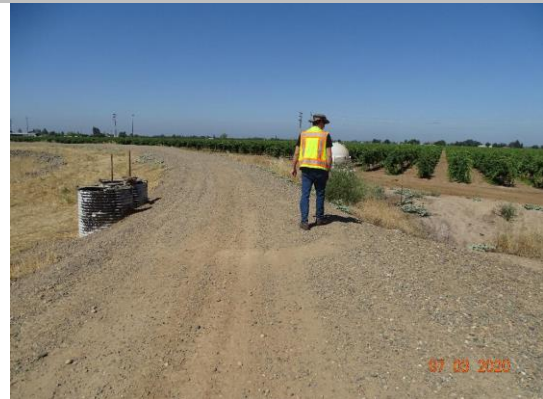
Photo 1 of 3 : UCIP_FA_2023_79070_86960.jpg

DS_ID:23871
 FS_ID:79070
 EP_NO: N/A
 Repair Type: Non-Urgent
 EVAL Issue:
 Crossing Status: Found
 UCIP Comments: 07/03/2020 Crossing evaluated as "Non-Urgent" because there was no permit found authorizing this pipe. (A. McDonald - DWR UCIP)
 06/12/2014 Slide gate may be rusted shut or does not function. Heavy sediment buildup in pipe. Lid on CMP riser needs repair. (DWR UCIP)
 FIELD_STRUCT_DESC: 1 of 2: 36-inch corrugated metal drainage pipe through the levee, 7 feet below the crown. Slide gate in 48-inch corrugated metal riser unit on the waterside (WS) slope. Concrete U-shaped headwall on both ends. Flap gate on the WS end. Cobble grouted outlet. Cobble grouted intake on the landside (LS). [Additional Reference(s): DWR Levee Log, 1978 (HLM 1.51). USACE San Joaquin O&M Manual 612.2, 1967, (HLM 1.51), 36-inch pipe listed].
 FS Date: 7/3/2020

Overview of levee crown looking d/s.

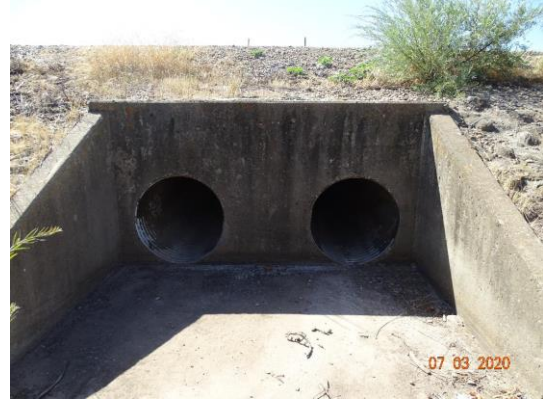
Photo 2 of 3 : UCIP_FA_2023_79070_86961.jpg

Two pipe inlets and headwall at the LS levee toe.

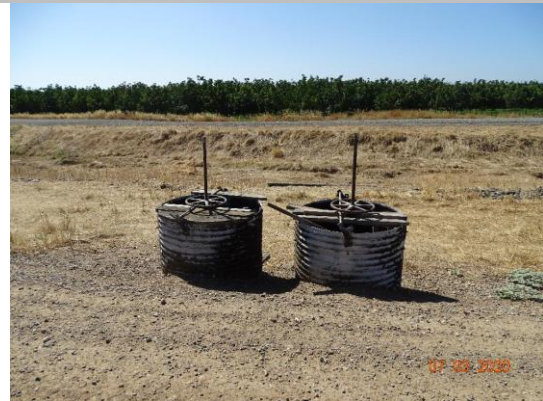
Photo 3 of 3 : UCIP_FA_2023_79070_86962.jpg

Two slide gates and risers on the WS levee slope.

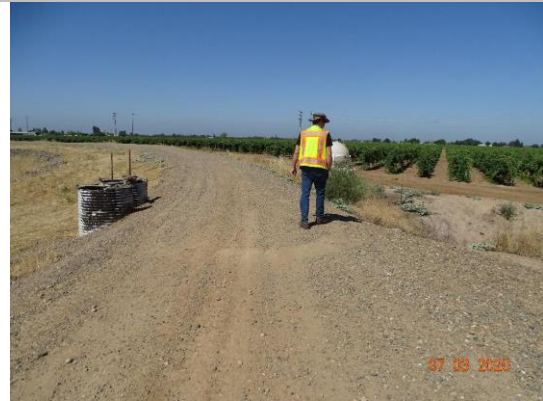
Photo 1 of 3 : UCIP_FA_2023_79071_86965.jpg

Comment Code						
Inspector Comment						
DS_ID:23897 FS_ID:79071 EP_NO: N/A Repair Type: Non-Urgent EVAL Issue: Crossing Status: Found UCIP Comments: 07/03/2020 Crossing evaluated as "Non-Urgent" because there was no permit found authorizing this pipe. (A. McDonald - DWR UCIP) 06/12/2014 Slide gate not functional or rusted in place. No lid on CMP riser at WS slope. (DWR UCIP) FIELD_STRUCT_DESC: 2 of 2: 36-inch corrugated metal drainage pipe through the levee, 7 feet below the crown. Slide gate in 48-inch corrugated metal riser unit on the waterside (WS) slope. Concrete U-shaped headwall on both ends. Flap gate on the WS end. Cobble grouted outlet. Cobble grouted intake on the landside (LS). [Additional Reference(s): DWR Levee Log, 1978 (HLM 1.51). USACE San Joaquin O&M Manual 612.2, 1967, (HLM 1.51), 36-inch pipe listed]. FS Date: 7/3/2020

Overview of levee crown looking d/s.

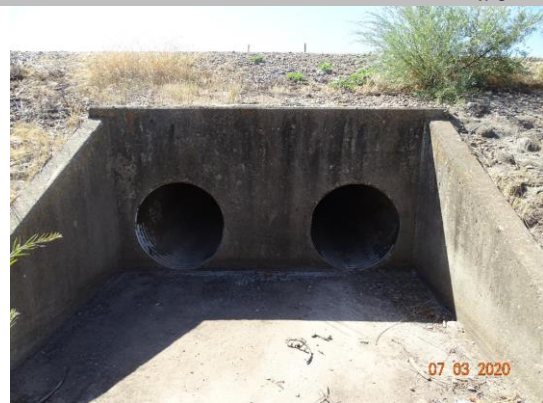
Photo 2 of 3 : UCIP_FA_2023_79071_86966.jpg

Two pipe inlets and headwall at the LS levee toe.

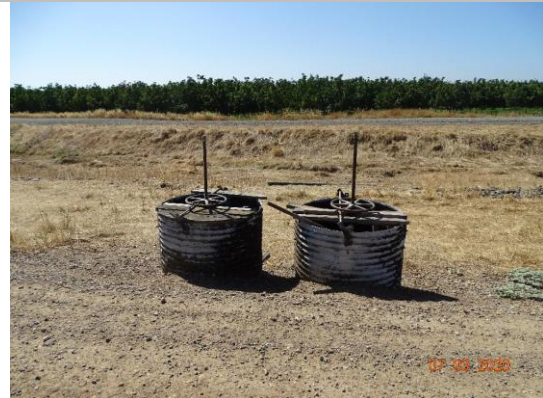
Photo 3 of 3 : UCIP_FA_2023_79071_86967.jpg

Two risers and slide gates on the WS levee slope.

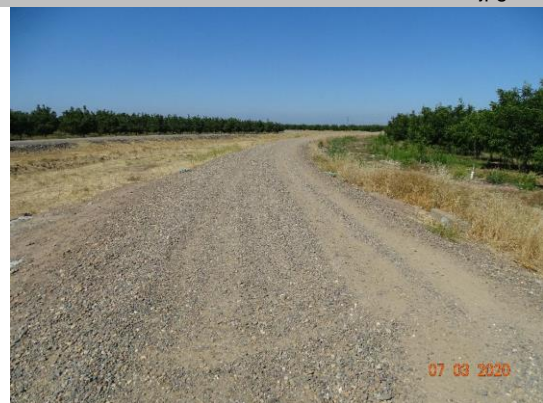
Photo 1 of 3 : UCIP_FA_2023_79072_86978.jpg

DS_ID:23872
 FS_ID:79072
 EP_NO: N/A
 Repair Type: Non-Urgent
 EVAL Issue:
 Crossing Status: Found
 UCIP Comments: 07/03/2020 Crossing evaluated as "Non-Urgent" because there was no permit found authorizing this pipe. (A. McDonald - DWR UCIP)
 FIELD_STRUCT_DESC: 24-inch corrugated metal drainage pipe through the levee, 5.5 feet below the crown. Concrete U-shaped headwall on both ends. Flap gate on the waterside (WS) end. Cobble grouted outlet. Cobble grouted intake on the landside (LS). [Additional Reference(s): DWR Levee Log, 1978, (HLM 1.82). USACE San Joaquin O&M Manual 612.2, 1967, (HLM 1.82), 24-inch pipe listed].
 FS Date: 7/3/2020

Overview of levee crown looking d/s.

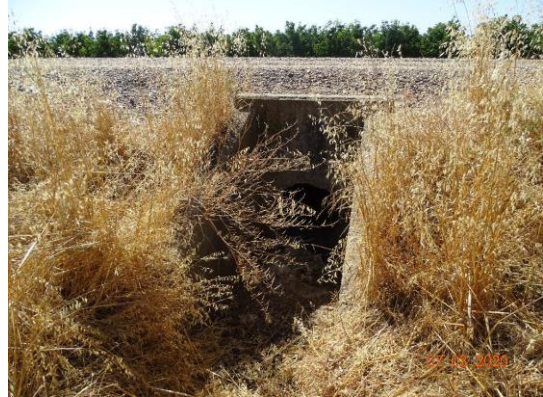
Photo 2 of 3 : UCIP_FA_2023_79072_86979.jpg

Pipe inlet and headwall located at the LS levee toe.

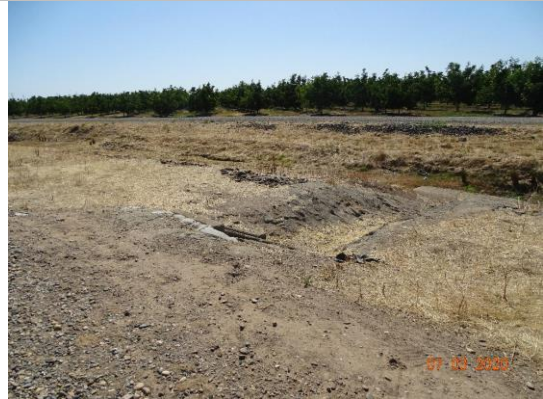
Photo 3 of 3 : UCIP_FA_2023_79072_86980.jpg

Overview of WS channel looking from the levee crown.

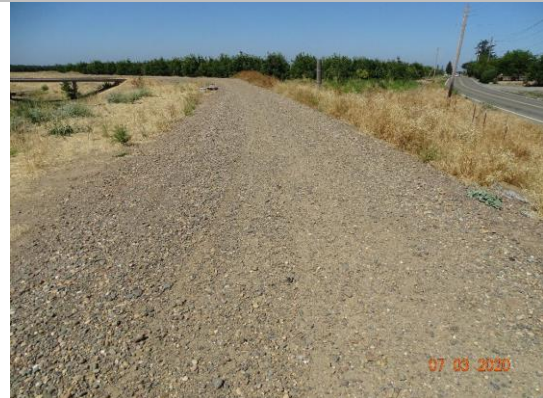
Photo 1 of 3 : UCIP_FA_2023_79074_86988.jpg

Comment Code					
Inspector Comment					
DS_ID:23874					
FS_ID:79074					
EP_NO: N/A					
Repair Type: Non-Urgent					
EVAL Issue:					
Crossing Status: Found					
UCIP Comments: 07/03/2020 Crossing evaluated as "Non-Urgent" because there was no permit found authorizing this pipe. (A. McDonald - DWR UCIP)					
FIELD_STRUCT_DESC: 24-inch corrugated metal drainage pipe through the levee, 6 feet below the crown. Concrete U-shaped headwall on both ends. Flap gate on the waterside (WS) end. Cobble grouted outlet. Cobble grouted intake on the landside (LS). [Additional Reference(s): DWR Levee Log, 1978, (HLM 2.05). USACE San Joaquin O&M Manual 612.2, 1967, (HLM 2.05), 24-inch pipe listed].					
FS Date: 7/3/2020

Overview of levee crown looking d/s.

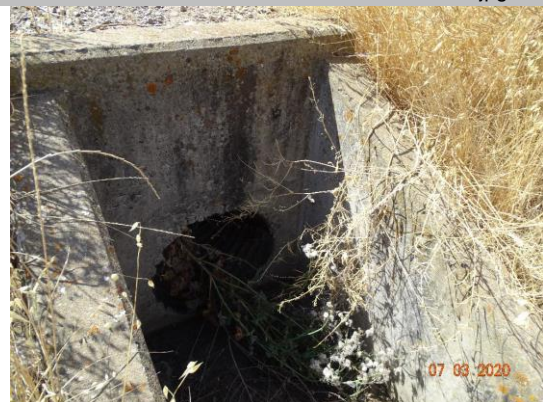
Photo 2 of 3 : UCIP_FA_2023_79074_86989.jpg

Inlet pipe and headwall located at the LS levee toe.

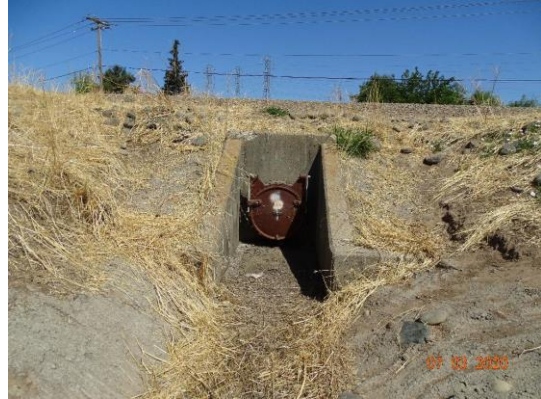
Photo 3 of 3 : UCIP_FA_2023_79074_86990.jpg

Outlet pipe, flap gate, and headwall located at the WS levee toe.

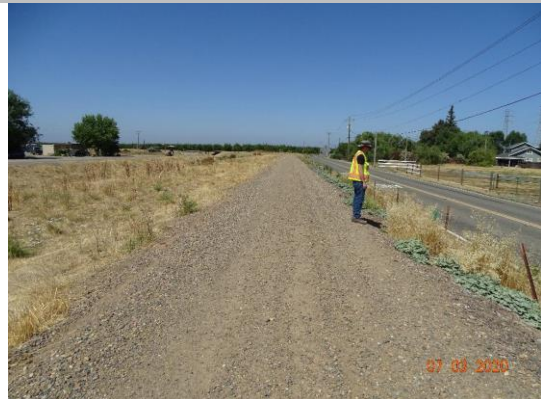
Photo 1 of 3 : UCIP_FA_2023_79419_86991.jpg

DS_ID:23875
 FS_ID:79419
 EP_NO: N/A
 Repair Type: Non-Urgent
 EVAL Issue: 5, Pipe Damage
 Crossing Status: Found
 UCIP Comments: 03/31/2023 Record updated from Urgent to Non-Urgent. LoF is equal to 5 due to pipe surface damage corrosion, integrity issues are not found. Crossing will be monitored until funding becomes available for rehabilitation. (O.Yakimov - DWR UCIP).
 07/03/2020 Crossing evaluated as "Non-Urgent" because there was no permit found authorizing this pipe. Video inspection performed on 04-22-2020. (A. McDonald - DWR UCIP)
 FIELD_STRUCT_DESC: 12-inch corrugated metal drainage pipe through the levee, 5.5 feet below the crown. Flap gate on the waterside (WS) end. Drop inlet with grate at the landside (LS) toe. Cobble grouted outlet. [Additional Reference(s): DWR Levee Log, 1978, (HLM 2.14). USACE San Joaquin O&M Manual 612.2, 1967, (HLM 2.14), 12-inch pipe listed].
 FS Date: 7/3/2020

Overview of levee crown looking d/s.

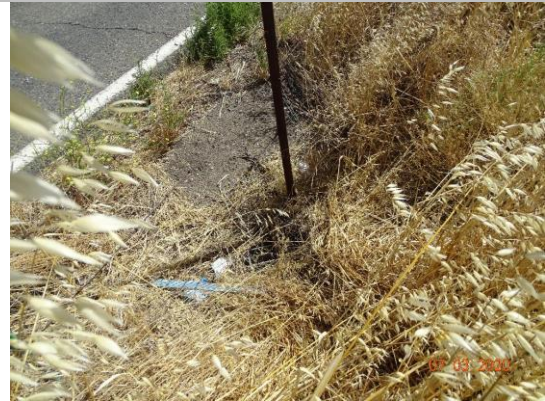
Photo 2 of 3 : UCIP_FA_2023_79419_86992.jpg

View of pipe inlet at the LS levee toe.

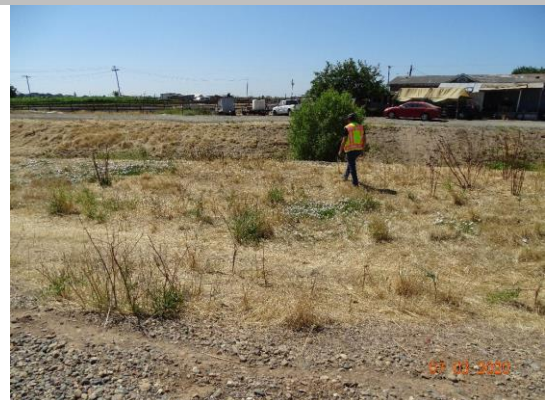
Photo 3 of 3 : UCIP_FA_2023_79419_86993.jpg

View of WS berm and channel looking from the levee crown.

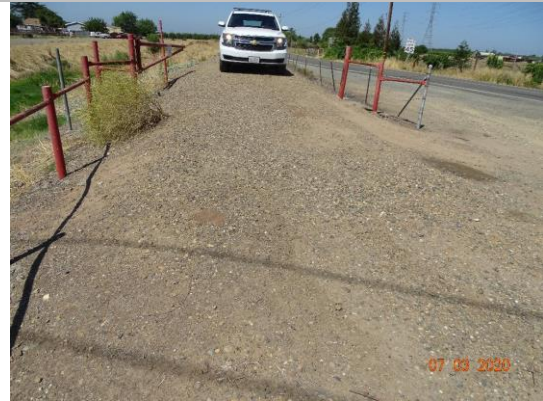
Photo 1 of 3 : UCIP_FA_2023_79076_86996.jpg

Comment Code					
Inspector Comment					
DS_ID:23876 FS_ID:79076 EP_NO: N/A Repair Type: Non-Urgent EVAL Issue: Crossing Status: Found UCIP Comments: 07/03/2020 Crossing evaluated as "Non-Urgent" because there was no permit found authorizing this pipe. (A. McDonald - DWR UCIP) 06/12/2014 Concrete inlet at LS of East Kettleman road is damaged...may or may not be a hazard. (DWR UCIP) FIELD_STRUCT_DESC: 24-inch corrugated metal drainage pipe through the levee, 5 feet below the crown. Concrete U-shaped headwall on the waterside (WS) end. Flap gate on the WS end. Cobble grouted outlet. 36-inch concrete catch basin on the landside (LS) end. [Additional Reference(s): DWR Levee Log, 1978, (HLM 2.22). USACE San Joaquin O&M Manual 612.2, 1967, (HLM 2.22), 24-inch pipe listed]. FS Date: 7/3/2020

Overview of levee crown looking d/s.
