**Flood Control Project Maintenance
Levee Inspections**

Maintenance Issue Types Only, Levee Inspection Report By Mile - Fall 2023

San Joaquin County Flood Control and Water Conservation District

Waterway	Bank	Unit Miles	Inspection Start/End	Inspector
Unit No. 01 Littlejohn Creek	Left	2.59	10/20/2023 10/20/2023	Alberto De Leon

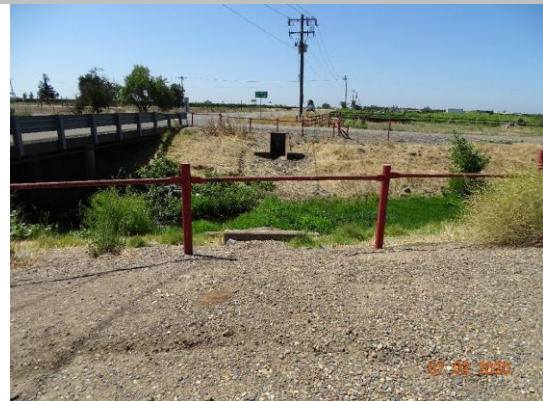
Photo 2 of 3 : UCIP_FA_2023_79076_86997.jpg

View of channel on WS and opposite levee.

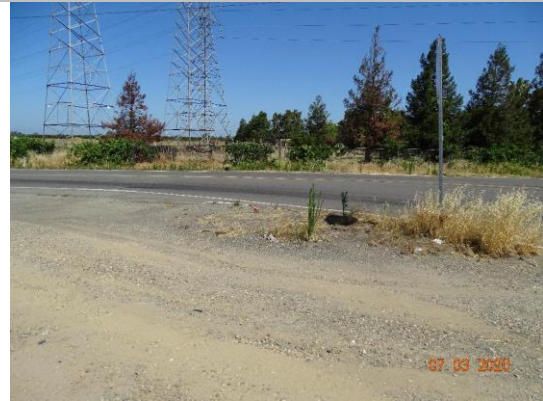
Photo 3 of 3 : UCIP_FA_2023_79076_86998.jpg

View of LS and pipe inlet.

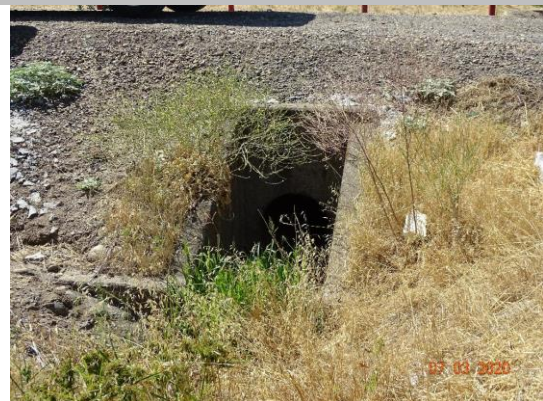
Photo 1 of 3 : UCIP_FA_2023_79077_87021.jpg

DS_ID:23878
 FS_ID:79077
 EP_NO: N/A
 Repair Type: Non-Urgent
 EVAL Issue:
 Crossing Status: Found
 UCIP Comments: 07/03/2020 Crossing evaluated as "Non-Urgent" because there was no permit found authorizing this pipe. (A. McDonald - DWR UCIP)
 FIELD_STRUCT_DESC: 24-inch corrugated metal drainage pipe through the levee, 5 feet below the crown. Concrete U-shaped headwall on both ends. Flap gate on the waterside (WS) end. Cobble grouted outlet. Cobble grouted intake on the landside (LS). [Additional Reference(s): DWR Levee Log, 1978, (HLM 2.24). USACE San Joaquin O&M Manual 612.2, 1967, (HLM 2.24), 24-inch pipe listed].
 FS Date: 7/3/2020

View of pipe inlet and headwall located at the LS levee toe.

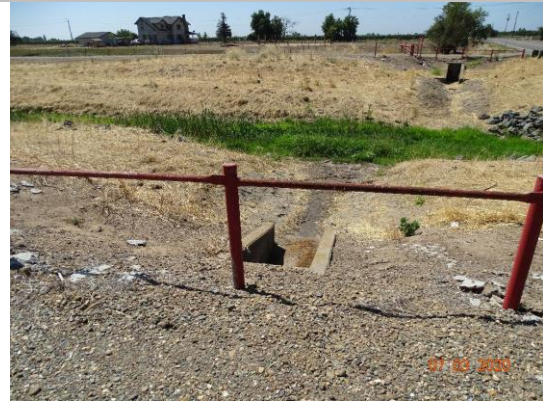
Photo 2 of 3 : UCIP_FA_2023_79077_87022.jpg

View of pipe outlet, WS channel, and opposite levee looking from the levee crown.

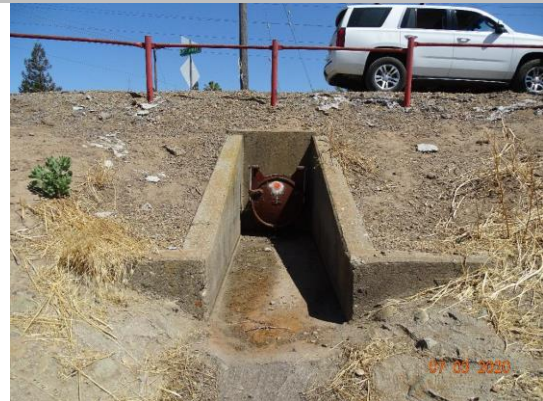
Photo 3 of 3 : UCIP_FA_2023_79077_87023.jpg

View of pipe outlet, flap gate, and headwall located at the WS levee toe.

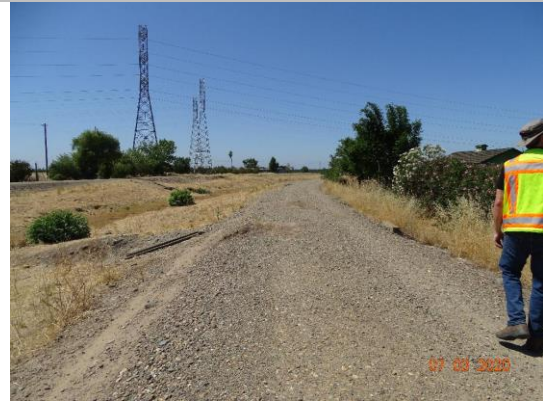
Photo 1 of 3 : UCIP_FA_2023_79078_87027.jpg

Comment Code					
Inspector Comment					
DS_ID:23886					
FS_ID:79078					
EP_NO: N/A					
Repair Type: Non-Urgent					
EVAL Issue:					
Crossing Status: Found					
UCIP Comments: 07/03/2020 Crossing evaluated as "Non-Urgent" because there was no permit found authorizing this pipe. (A. McDonald - DWR UCIP)					
FIELD_STRUCT_DESC: 24-inch corrugated metal drainage pipe through the levee, 4.5 feet below the crown. Concrete U-shaped headwall on both ends. Flap gate on the waterside (WS) end. Cobble grouted outlet. Cobble grouted intake on the landside (LS). [Additional Reference(s): DWR Levee Log, 1978, (HLM 2.44). USACE San Joaquin O&M Manual 612.2, 1967, (HLM 2.44), 24-inch pipe listed].					
FS Date: 7/3/2020

Overview of levee crown looking d/s.

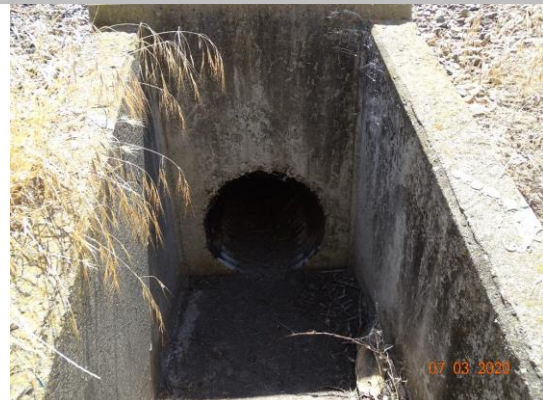
Photo 2 of 3 : UCIP_FA_2023_79078_87028.jpg

View of pipe inlet and headwall located at the LS levee toe.

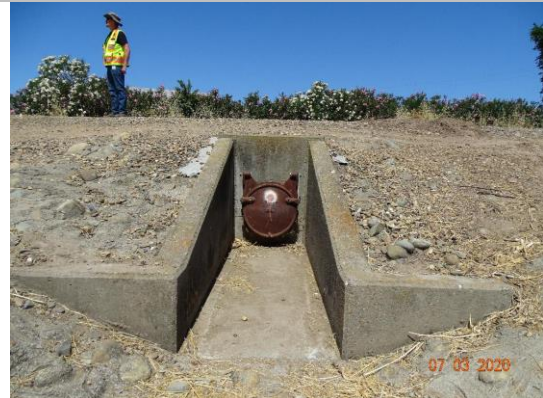
Photo 3 of 3 : UCIP_FA_2023_79078_87029.jpg

View of pipe outlet, flap gate, and headwall located at the WS levee toe.

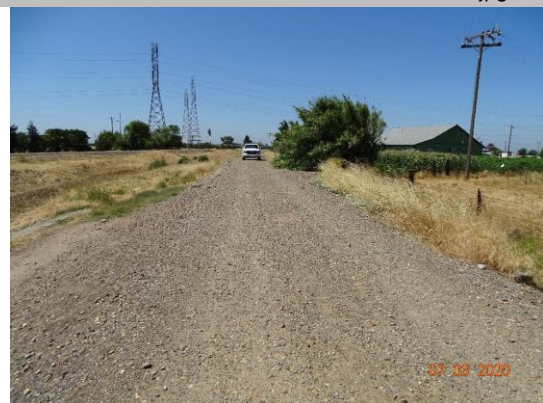
Photo 1 of 3 : UCIP_FA_2023_79079_87030.jpg

DS_ID:23887
 FS_ID:79079
 EP_NO: N/A
 Repair Type: Non-Urgent
 EVAL Issue:
 Crossing Status: Found
 UCIP Comments: 07/03/2020 Crossing evaluated as "Non-Urgent" because there was no permit found authorizing this pipe. (A. McDonald - DWR UCIP)
 FIELD_STRUCT_DESC: 24-inch corrugated metal drainage pipe through the levee, 5.5 feet below the crown. Concrete U-shaped headwall on both ends. Flap gate on the waterside (WS) end. Cobble grouted outlet. Cobble grouted intake on the landside (LS). [Additional Reference(s): DWR Levee Log, 1978, (HLM 2.48). USACE San Joaquin O&M Manual 612.2, 1967, (HLM 2.48), 24-inch pipe listed].
 FS Date: 7/3/2020

Overview of levee crown looking d/s.

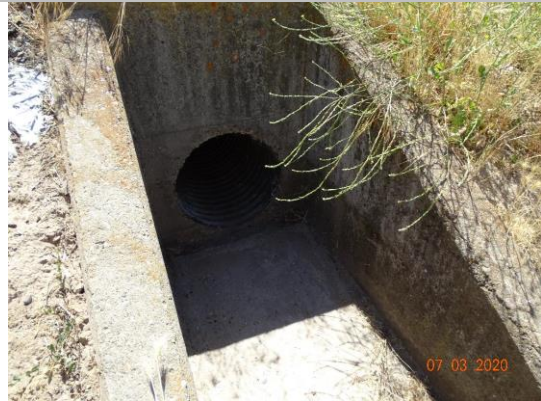
Photo 2 of 3 : UCIP_FA_2023_79079_87031.jpg

View of pipe inlet and headwall located at the LS levee toe.

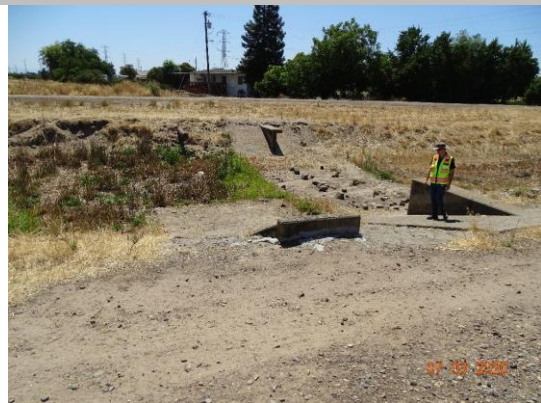
Photo 3 of 3 : UCIP_FA_2023_79079_87032.jpg

View of pipe outlet and channel located on the WS.

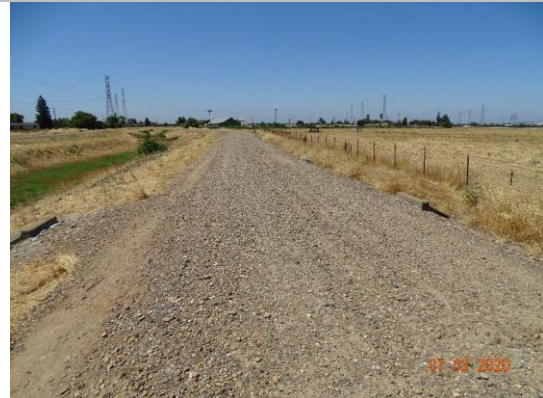
Photo 1 of 3 : UCIP_FA_2023_79080_87034.jpg

Comment Code					
Inspector Comment					
DS_ID:23888					
FS_ID:79080					
EP_NO: N/A					
Repair Type: Non-Urgent					
EVAL Issue:					
Crossing Status: Found					
UCIP Comments: 07/03/2020 Crossing evaluated as "Non-Urgent" because there was no permit found authorizing this pipe. Video inspection performed on 04-22-2020. (A. McDonald - DWR UCIP)					
FIELD_STRUCT_DESC: 24-inch corrugated metal drainage pipe through the levee, 6 feet below the crown. Concrete U-shaped headwall on both ends. Flap gate on the waterside (WS) end. Cobble grouted outlet. Cobble grouted intake on the landside (LS). [Additional Reference(s): DWR Levee Log, 1978, (HLM 2.58). USACE San Joaquin O&M Manual 612.2, 1967, (HLM 2.58), 24-inch pipe listed].					
FS Date: 7/3/2020

Overview of levee crown looking d/s.

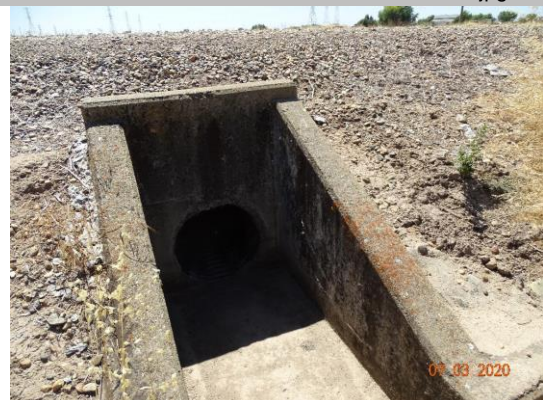
Photo 2 of 3 : UCIP_FA_2023_79080_87035.jpg

View of pipe inlet and headwall located at the LS levee toe.

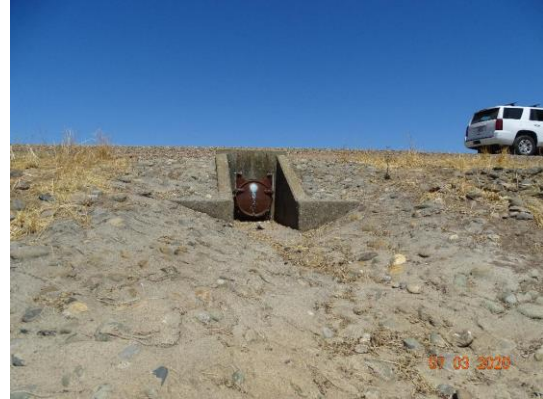
Photo 3 of 3 : UCIP_FA_2023_79080_87036.jpg

View of pipe outlet, flap gate, headwall, and splash apron located on the WS levee slope.

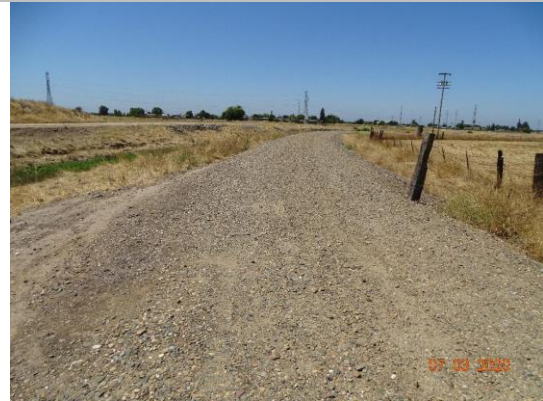
Photo 1 of 3 : UCIP_FA_2023_79081_87045.jpg

Comment Code					
Inspector Comment					
DS_ID:23890 FS_ID:79081 EP_NO: N/A Repair Type: Non-Urgent EVAL Issue: 5, Pipe Damage Crossing Status: Found UCIP Comments: 07/03/2020 Crossing evaluated as "No Action Needed." Permit and inspection requirements have been met. Video inspection performed on 04-22-2020. (A. McDonald - DWR UCIP) FIELD_STRUCT_DESC: 36-inch corrugated metal drainage pipe (CMP) through the levee, 7.0 feet below the crown. Concrete U-shaped headwall on both ends. Flap gate on the waterside (WS) end. Cobble grouted outlet. Cobble grouted intake on the landside (LS). (Positive closure device installed on intake end under Permit No. 17426, 2003 - Western Dairy Design Associates, Inc.). [Additional Reference(s): DWR Levee Log, 1978, (HLM 2.73). USACE San Joaquin O&M Manual 612.2, 1967, (HLM 2.73), 36-inch pipe listed]. FS Date: 7/3/2020

Overview of levee crown looking d/s.

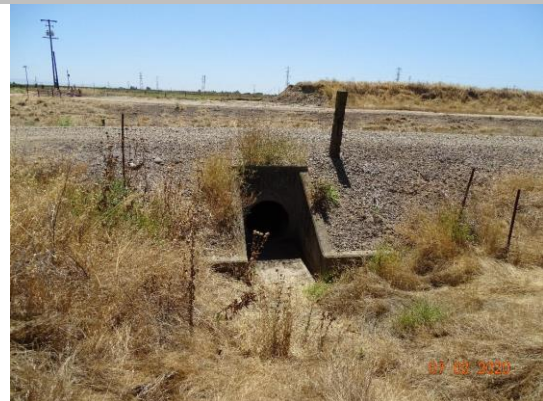
Photo 2 of 3 : UCIP_FA_2023_79081_87046.jpg

View of pipe inlet and headwall located at the LS levee toe.

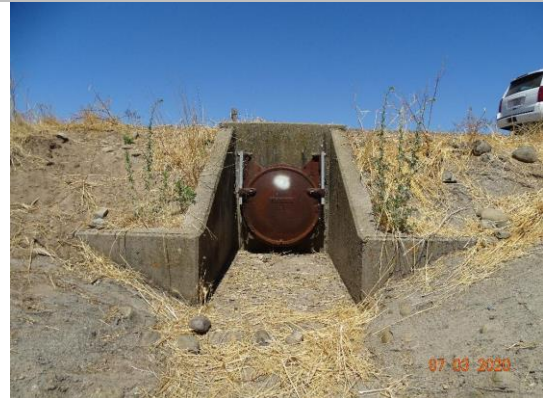
Photo 3 of 3 : UCIP_FA_2023_79081_87047.jpg

View of pipe outlet, flap gate, headwall, and splash apron located at the WS levee toe.

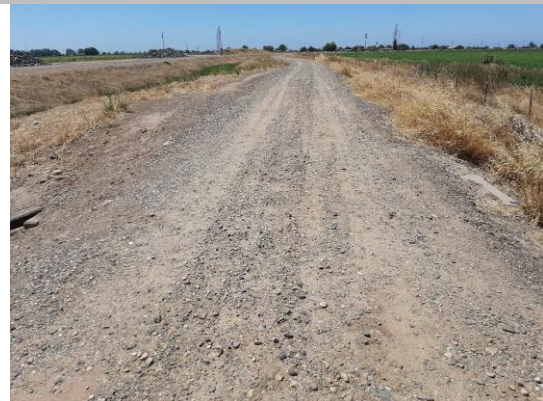
Photo 1 of 3 : UCIP_FA_2023_79082_87048.jpg

DS_ID:23891
 FS_ID:79082
 EP_NO: N/A
 Repair Type: Non-Urgent
 EVAL Issue:
 Crossing Status: Found
 UCIP Comments: 07/03/2020 Crossing evaluated as "Non-Urgent" because there was no permit found authorizing this pipe. Video inspection performed on 04-22-2020. (A. McDonald - DWR UCIP)
 FIELD_STRUCT_DESC: 24-inch corrugated metal drainage pipe through the levee, 6 feet below the crown. Concrete U-shaped headwall on both ends. Flap gate on the waterside (WS) end. Cobble grouted outlet. Cobble grouted intake on the landside (LS). [Additional Reference(s): DWR Levee Log, 1978, (HLM 2.88). USACE San Joaquin O&M Manual 612.2, 1967, (HLM 2.88), 24-inch pipe listed].
 FS Date: 7/3/2020

Overview of levee crown looking d/s.

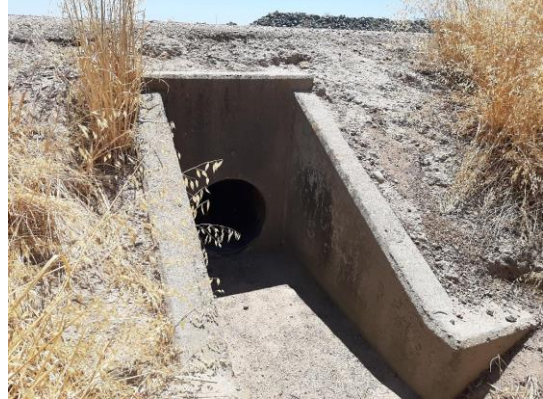
Photo 2 of 3 : UCIP_FA_2023_79082_87049.jpg

View of pipe inlet and headwall located at the LS levee toe.

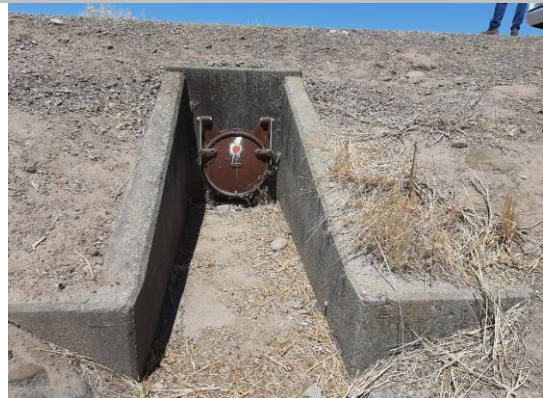
Photo 3 of 3 : UCIP_FA_2023_79082_87050.jpg

View of pipe outlet, flap gate, and headwall located at the WS levee toe.

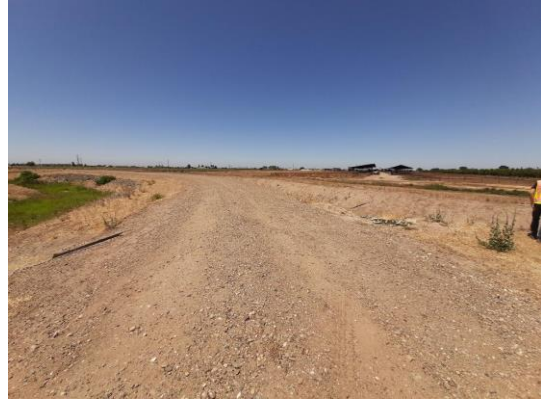
Photo 1 of 3 : UCIP_FA_2023_79083_87054.jpg

Comment Code					
Inspector Comment					
DS_ID:23892 FS_ID:79083 EP_NO: N/A Repair Type: No Action Needed EVAL Issue: Crossing Status: Found UCIP Comments: 07/03/2020 Crossing evaluated as "No Action Needed" because this is an abandoned encroachment. Video inspection performed on 02-21-2020. (A. McDonald - DWR UCIP) 06/11/2014 Pipe abandoned and if so should be done so properly. Verify if possible pipe filled with concrete. (DWR UCIP) FIELD_STRUCT_DESC: *ABANDONED* 24-inch corrugated metal drainage pipe through the levee, 6.5 feet below the crown. Concrete U-shaped headwall on both ends. Flap gate on the waterside (WS) end. Cobble grouted outlet. Cobble grouted intake on the landside (LS). (Intake end plugged, and pipe filled with concrete under Permit No. 17426, 2003 - Western Dairy Design Associates, Inc.). [Additional Reference(s): DWR Levee Log, 1978, (HLM 3.04). USACE San Joaquin O&M Manual 612.2, 1967, (HLM 3.04), 24-inch pipe listed]. FS Date: 7/3/2020

Overview of levee crown looking d/s.

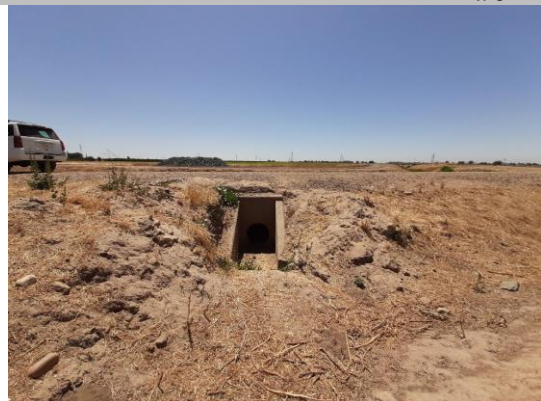
Photo 2 of 3 : UCIP_FA_2023_79083_87055.jpg

View of pipe inlet and headwall located at the LS levee toe.

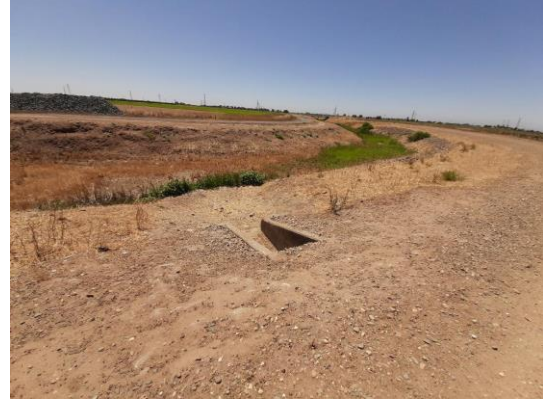
Photo 3 of 3 : UCIP_FA_2023_79083_87056.jpg

View of pipe outlet and WS channel.

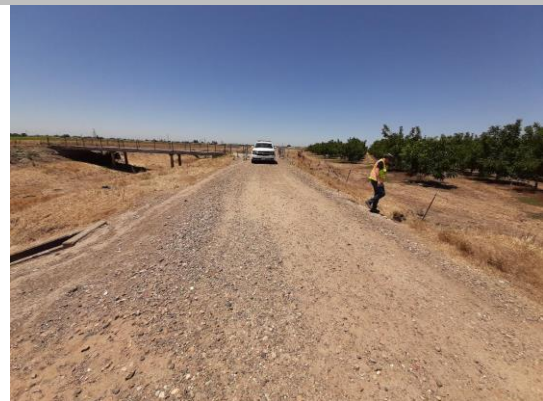
Photo 1 of 3 : UCIP_FA_2023_78626_87058.jpg

DS_ID:23893
 FS_ID:78626
 EP_NO: N/A
 Repair Type: Non-Urgent
 EVAL Issue:
 Crossing Status: Found
 UCIP Comments: 07/03/2020 Crossing evaluated as "Non-Urgent" because there was no permit found authorizing this pipe. (A. McDonald - DWR UCIP)
 FIELD_STRUCT_DESC: 24-inch corrugated metal drainage pipe through the levee, 4.6 feet below the crown. Flap gate on the waterside (WS) end. [Additional Reference(s): DWR Levee Log, 1978, (HLM 3.15). USACE San Joaquin O&M Manual 612.2, 1967, (HLM 3.15), 24-inch pipe listed].
 FS Date: 7/3/2020

Overview of levee crown looking d/s.

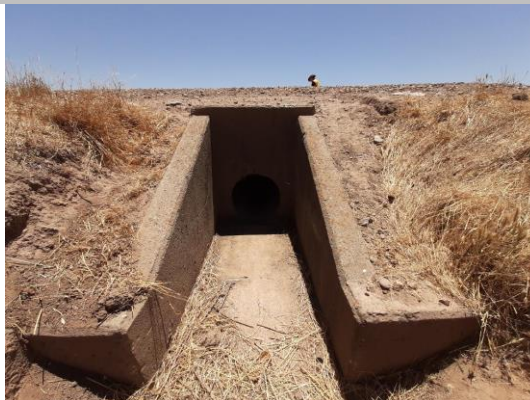
Photo 2 of 3 : UCIP_FA_2023_78626_87059.jpg

View of pipe inlet and headwall located at the LS levee toe.

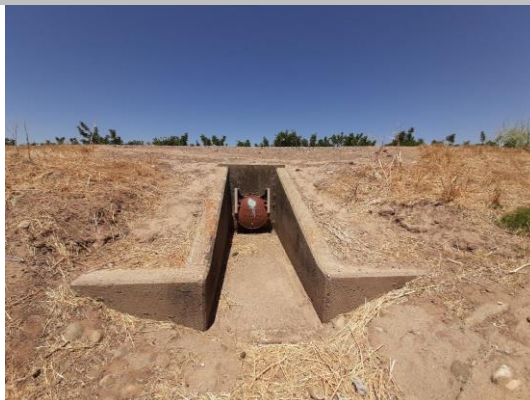
Photo 3 of 3 : UCIP_FA_2023_78626_87060.jpg

View of pipe outlet, flap gate, and headwall located at the WS levee toe.

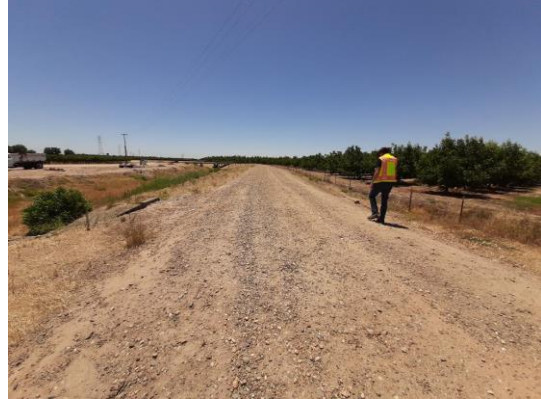
Photo 1 of 3 : UCIP_FA_2023_79084_87065.jpg

Comment Code					
Inspector Comment					
DS_ID:23895					
FS_ID:79084					
EP_NO: N/A					
Repair Type: Non-Urgent					
EVAL Issue:					
Crossing Status: Found					
UCIP Comments: 07/03/2020 Crossing evaluated as "Non-Urgent" because there was no permit found authorizing this pipe. (A. McDonald - DWR UCIP)					
FIELD_STRUCT_DESC: 24-inch corrugated metal drainage pipe through the levee, 5 feet below the crown. Concrete U-shaped headwall on both ends. Flap gate on the waterside (WS) end. Cobble grouted outlet. Cobble grouted intake on the landside (LS). [Additional Reference(s): DWR Levee Log, 1978, (HLM 3.47). USACE San Joaquin O&M Manual 612.2, 1967, (HLM 3.47), 24-inch pipe listed].					
FS Date: 7/3/2020

Overview of levee crown looking d/s.

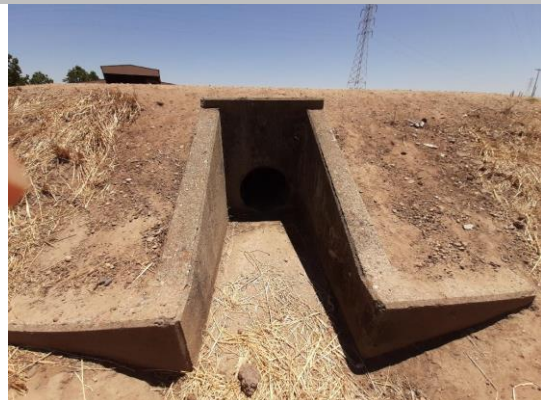
Photo 2 of 3 : UCIP_FA_2023_79084_87066.jpg

View of pipe inlet and headwall located at the LS levee toe.

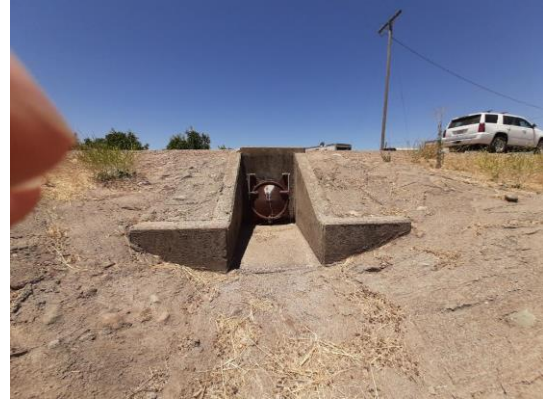
Photo 3 of 3 : UCIP_FA_2023_79084_87067.jpg

View of pipe outlet, flap gate, and headwall located at the WS levee toe.

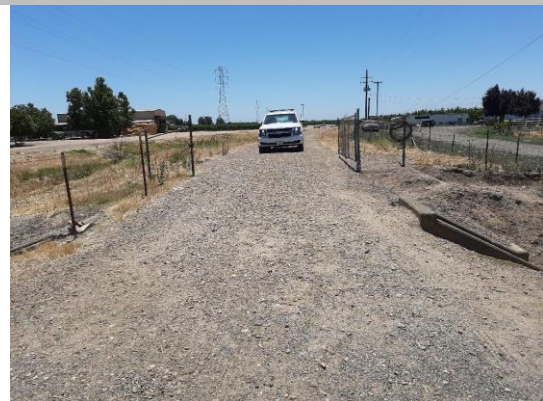
Photo 1 of 3 : UCIP_FA_2023_79085_87068.jpg

DS_ID:23896
 FS_ID:79085
 EP_NO: N/A
 Repair Type: Non-Urgent
 EVAL Issue:
 Crossing Status: Found
 UCIP Comments: 07/03/2020 Crossing evaluated as "Non-Urgent" because there was no permit found authorizing this pipe. Video inspection performed on 04-22-2020. (A. McDonald - DWR UCIP)
 FIELD_STRUCT_DESC: 24-inch corrugated metal drainage pipe through the levee, 4.5 feet below the crown. Concrete U-shaped headwall on both ends. Flap gate on the waterside (WS) end. Cobble grouted outlet. Cobble grouted intake on the landside (LS). [Additional Reference(s): DWR Levee Log, 1978, (HLM 3.55). USACE San Joaquin O&M Manual 612.2, 1967, (HLM 3.55), 24-inch pipe listed].
 FS Date: 7/3/2020

Overview of levee crown looking d/s.

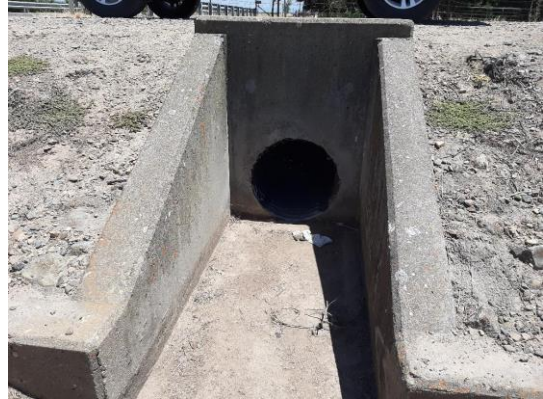
Photo 2 of 3 : UCIP_FA_2023_79085_87069.jpg

View of pipe inlet and headwall located at the LS levee toe.

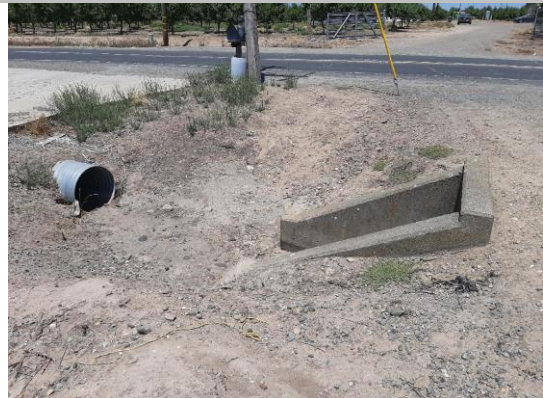
Photo 3 of 3 : UCIP_FA_2023_79085_87070.jpg

Drainage pipe under driveway leading to the inlet at the LS levee toe.

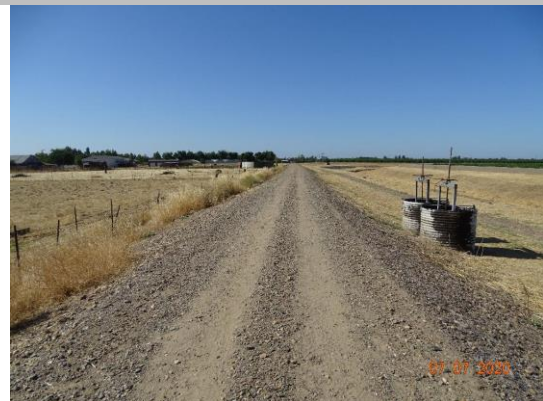
Photo 1 of 3 : UCIP_FA_2023_78630_87072.jpg

Comment Code						
Inspector Comment						
DS_ID:23925						
FS_ID:78630						
EP_NO: N/A						
Repair Type: Non-Urgent						
EVAL Issue:						
Crossing Status: Found						
UCIP Comments: 07/07/2020 Crossing evaluated as "Non-Urgent" because there was no permit found authorizing this pipe. Video inspection performed on 05-07-2020. (A. McDonald - DWR UCIP)Gate valve rusted in place. No lid or cover on Standpipe on WS slope. FIELD_STRUCT_DESC: 1 of 2: 42-inch corrugated metal drainage pipe through the levee, 7.0 feet below the crown. Slide gate in a 56-inch corrugated metal riser unit on the waterside (WS) slope. Flap gate on the WS end. Concrete headwall on both ends. [Additional Reference(s): DWR Levee Log, 1978, (HLM 0.14). USACE San Joaquin O&M Manual 612.2, 1967, (HLM 0.14) 36-inch pipe listed].						
FS Date: 7/7/2020

Overview of levee crown looking d/s.

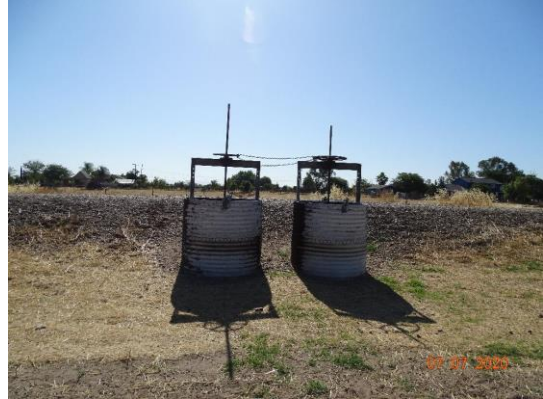
Photo 2 of 3 : UCIP_FA_2023_78630_87073.jpg

Two risers with gate valves located on the WS levee slope.

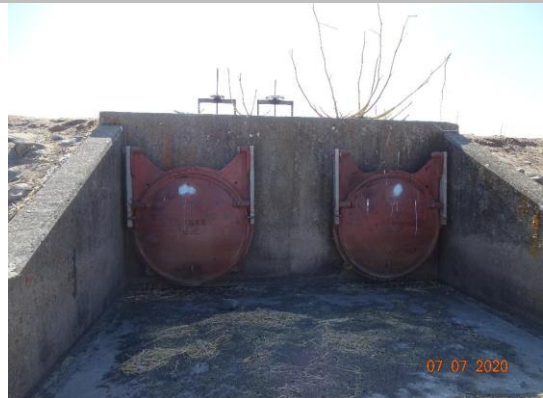
Photo 3 of 3 : UCIP_FA_2023_78630_87074.jpg

Two pipe outlets, flap gates, and headwall located on the WS berm.

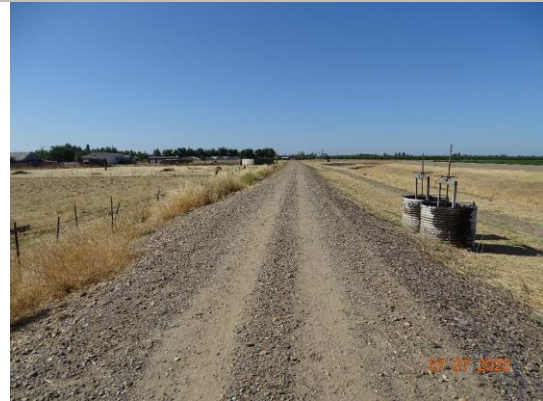
Photo 1 of 3 : UCIP_FA_2023_78631_87076.jpg

Comment Code					
Inspector Comment					
DS_ID:23930 FS_ID:78631 EP_NO: N/A Repair Type: Non-Urgent EVAL Issue: Crossing Status: Found UCIP Comments: 07/07/2020 Crossing evaluated as "Non-Urgent" because there was no permit found authorizing this pipe. (A. McDonald - DWR UCIP) 06/12/2014 No lid on riser and slide gate actuator rusted in place. (DWR UCIP) FIELD_STRUCT_DESC: 2 of 2: 42-inch corrugated metal drainage pipe through the levee, 7.0 feet below the crown. Slide gate in 56-inch corrugated metal riser unit on the waterside (WS) slope. Flap gate on the WS end. [Additional Reference(s): DWR Levee Log, 1978, (HLM 0.14). USACE San Joaquin O&M Manual 612.2, 1967, (HLM 0.14) 36-inch pipe listed]. FS Date: 7/7/2020

Overview of levee crown looking d/s.

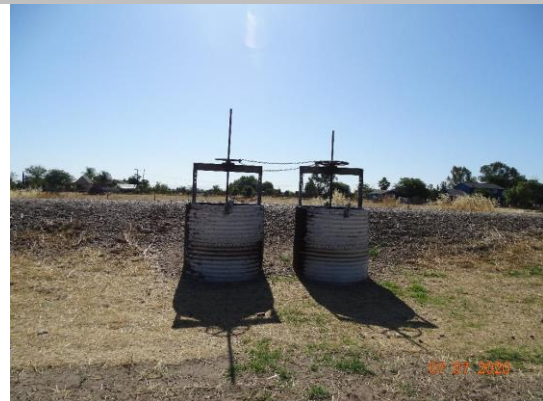
Photo 2 of 3 : UCIP_FA_2023_78631_87077.jpg

Two risers and gate valves located on the WS levee slope.

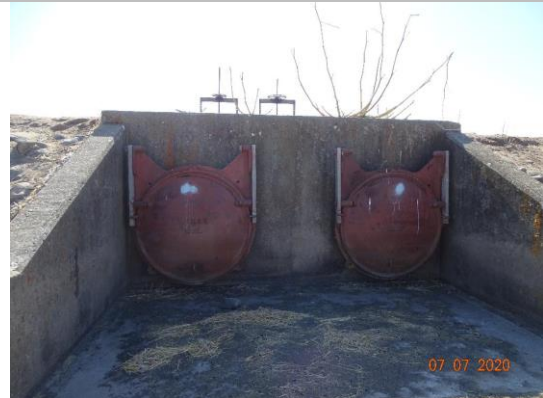
Photo 3 of 3 : UCIP_FA_2023_78631_87078.jpg

Two pipe outlets, flap gates, and headwall located on the WS berm.

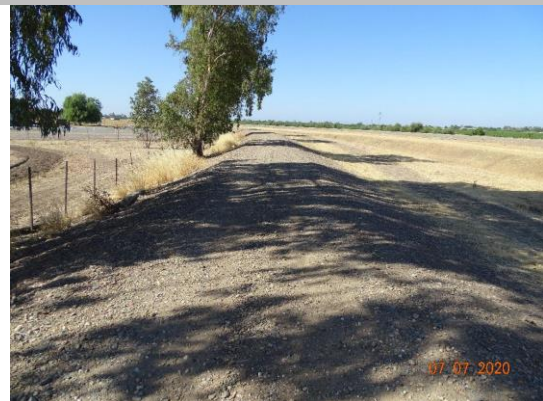
Photo 1 of 3 : UCIP_FA_2023_79096_87080.jpg

DS_ID:23900
 FS_ID:79096
 EP_NO: N/A
 Repair Type: Non-Urgent
 EVAL Issue:
 Crossing Status: Found
 UCIP Comments: 07/07/2020 Crossing evaluated as "Non-Urgent" because there was no permit found authorizing this pipe. (A. McDonald - DWR UCIP)
 FIELD_STRUCT_DESC: 24-inch corrugated metal drainage pipe through the levee, 6.5 feet below the crown. Concrete U-shaped headwall on both ends. Flap gate on the waterside (WS) end. Cobble grouted outlet. Cobble grouted intake on the landside (LS). [Additional Reference(s): DWR Levee Log, 1978, (HLM 0.40). USACE San Joaquin O&M Manual 612.2, 1967, (HLM 0.40), 24-inch pipe listed].
 FS Date: 7/7/2020

Overview of levee crown looking d/s.

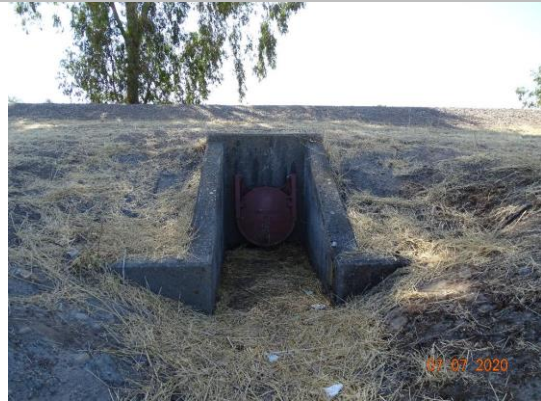
Photo 2 of 3 : UCIP_FA_2023_79096_87081.jpg

View of pipe outlet, flap gate, and headwall located on the WS berm.

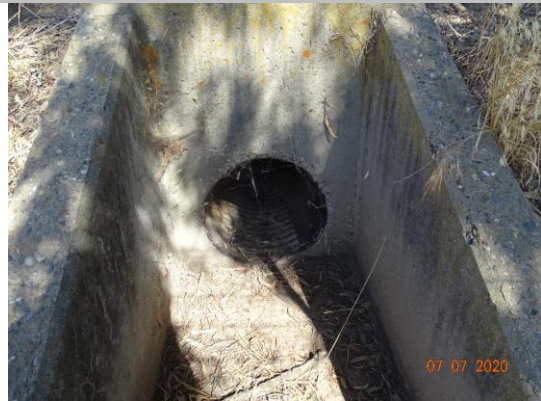
Photo 3 of 3 : UCIP_FA_2023_79096_87082.jpg

View of pipe inlet and headwall located at the LS levee toe.

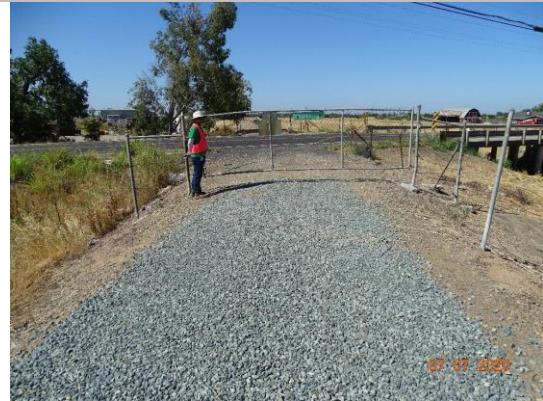
Photo 1 of 3 : UCIP_FA_2023_79097_87089.jpg

Comment Code						
Inspector Comment						
DS_ID:23901						
FS_ID:79097						
EP_NO: N/A						
Repair Type: Non-Urgent						
EVAL Issue:						
Crossing Status: Found						
UCIP Comments: 07/07/2020 Crossing evaluated as "Non-Urgent" because there was no permit found authorizing this pipe. (A. McDonald - DWR UCIP)						
FIELD_STRUCT_DESC: 24-inch corrugated metal drainage pipe through the levee, 7 feet below the crown. Concrete U-shaped headwall on both ends. Flap gate on the waterside (WS) end. Cobble grouted outlet. Cobble grouted intake on the landside (LS) end. [Additional Reference(s): DWR Levee Log, 1978, (HLM 0.48). USACE San Joaquin O&M Manual 612.2, 1967, (HLM 0.48), 24-inch pipe listed].						
FS Date: 7/7/2020

Overview of levee crown looking d/s.

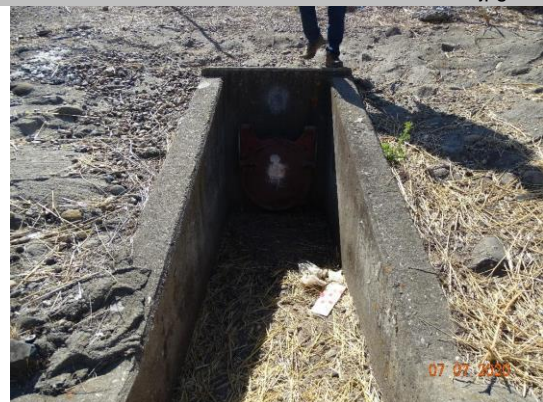
Photo 2 of 3 : UCIP_FA_2023_79097_87090.jpg

View of pipe outlet, flap gate, and headwall located at the WS levee toe.

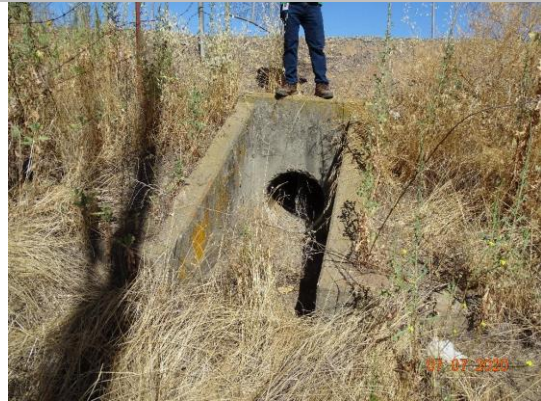
Photo 3 of 3 : UCIP_FA_2023_79097_87091.jpg

View of pipe inlet and headwall located at the LS levee toe.

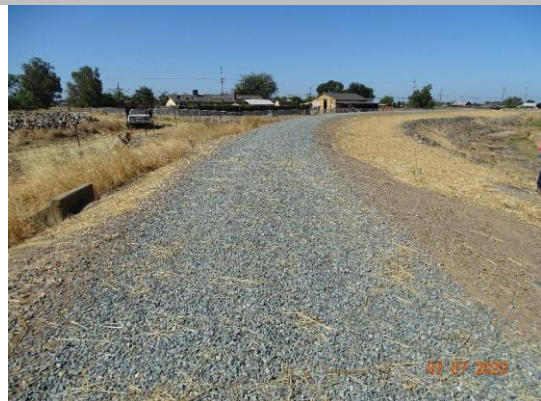
Photo 1 of 3 : UCIP_FA_2023_79098_87092.jpg

DS_ID:23902
 FS_ID:79098
 EP_NO: N/A
 Repair Type: Non-Urgent
 EVAL Issue:
 Crossing Status: Found
 UCIP Comments: 07/07/2020 Crossing evaluated as "Non-Urgent" because there was no permit found authorizing this pipe. (A. McDonald - DWR UCIP)
 FIELD_STRUCT_DESC: 24-inch corrugated metal drainage pipe through the levee, 4 feet below the crown. Concrete U-shaped headwall on both ends. Flap gate on the waterside (WS) end. Cobble grouted outlet. Cobble grouted intake on the landside (LS). [Additional Reference(s): DWR Levee Log, 1978, (HLM 0.61). USACE San Joaquin O&M Manual 612.2, 1967, (HLM 0.61), 24-inch pipe listed].
 FS Date: 7/7/2020

Overview of levee crown looking d/s.

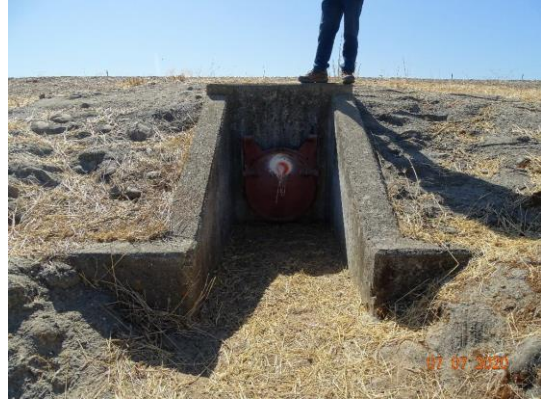
Photo 2 of 3 : UCIP_FA_2023_79098_87093.jpg

View of pipe outlet, flap gate, and headwall located at the WS levee toe.

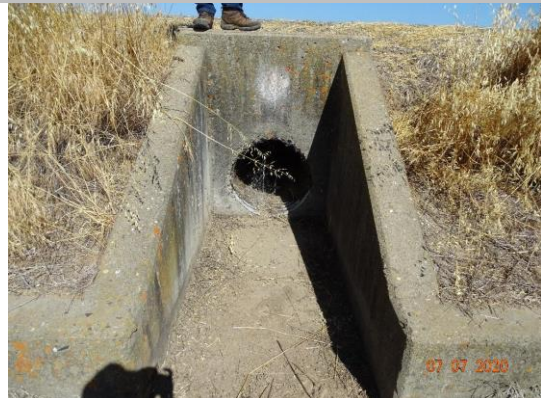
Photo 3 of 3 : UCIP_FA_2023_79098_87094.jpg

View of pipe inlet and headwall located at the LS levee toe.

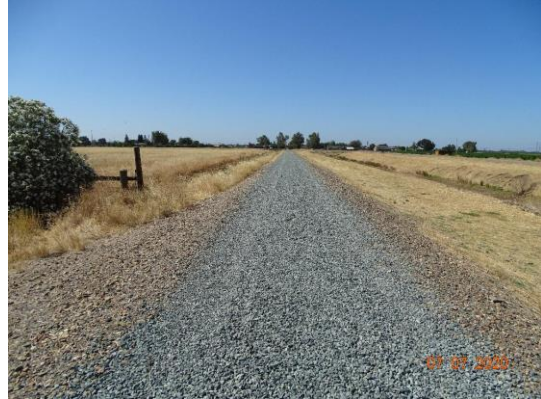
Photo 1 of 3 : UCIP_FA_2023_79099_87095.jpg

Comment Code						
Inspector Comment						
DS_ID:23903						
FS_ID:79099						
EP_NO: N/A						
Repair Type: Non-Urgent						
EVAL Issue:						
Crossing Status: Found						
UCIP Comments: 07/07/2020 Crossing evaluated as "Non-Urgent" because there was no permit found authorizing this pipe. Video inspection performed on 04-24-2020. (A. McDonald - DWR UCIP)						
FIELD_STRUCT_DESC: 24-inch corrugated metal drainage pipe through the levee, 5.5 feet below the crown. Concrete U-shaped headwalls on both ends. Flap gate on the waterside (WS) end. Cobble grouted outlet. Cobble grouted intake on the landside (LS) end.						
[Additional Reference(s): DWR Levee Log, 1978, (HLM 0.77). USACE San Joaquin O&M Manual 612.2, 1967, (HLM 0.77), 24-inch pipe listed].						
FS Date: 7/7/2020

Overview of levee crown looking d/s.

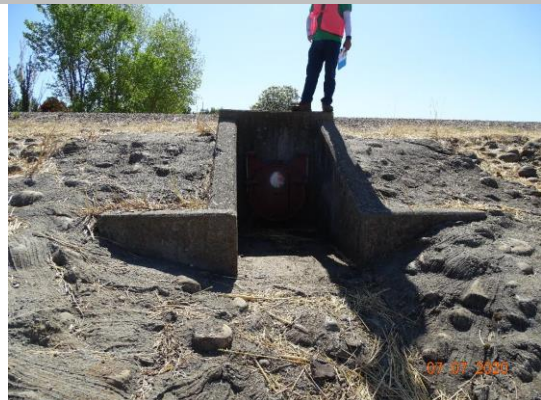
Photo 2 of 3 : UCIP_FA_2023_79099_87096.jpg

View of pipe outlet, flap gate, headwall, and splash apron located on the WS berm.

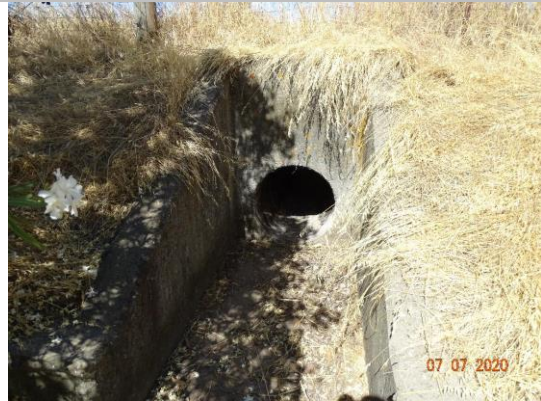
Photo 3 of 3 : UCIP_FA_2023_79099_87097.jpg

View of pipe inlet and headwall located at the LS levee toe.

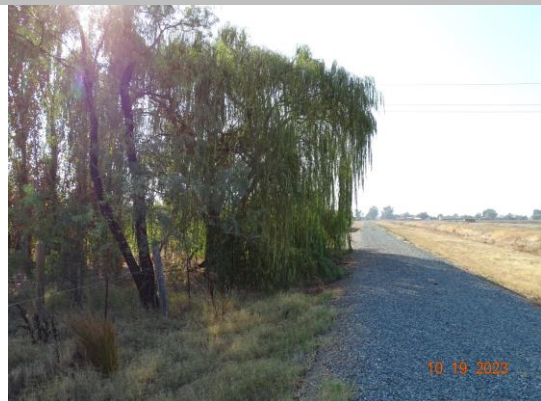
Photo 1 of 1 : FA_2023_NA0017_156_51_20231030_00072.jpg

LM Start	0.83	Rating **	U	Issue No.	51
LM End	0.83	Issue Type +	Ma	Location *	LS
Category	Earthen Levee			GPS Latitude/Longitude	
				Start	End
Item	Trim / Thin Trees			38.105998°	38.105998°
				-121.165757°	-121.165757°
DWR ID	DWR_NA0017_12_s_2020_51				
Comment Code					
T1 : Trim and thin trees to at least five feet above ground level to allow visibility of the ground and room to flood fight.					
Inspector Comment

View of untrimmed tree blocking visibility of the landside slope. Fall 2023

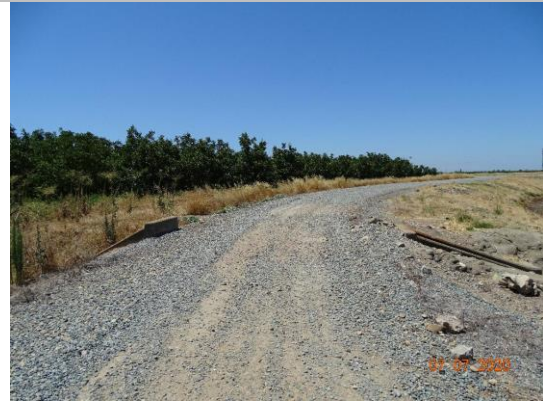
Photo 1 of 3 : UCIP_FA_2023_79100_87098.jpg

Comment Code						
Inspector Comment						
DS_ID:23904 FS_ID:79100 EP_NO: N/A Repair Type: Non-Urgent EVAL Issue: Crossing Status: Found UCIP Comments: 07/07/2020 Crossing evaluated as "Non-Urgent" because there was no permit found authorizing this pipe. (A. McDonald - DWR UCIP) FIELD_STRUCT_DESC: 24-inch corrugated metal drainage pipe through the levee, 2 feet below the crown. Concrete U-shaped headwalls on both ends. Flap gate on the waterside (WS) end. Cobble grouted outlet. Cobble grouted intake on the landside (LS). [Additional Reference(s): DWR Levee Log, 1978, (HLM 1.51). USACE San Joaquin O&M Manual 612.2, 1967, (HLM 1.51), 24-inch pipe listed]. FS Date: 7/7/2020

Overview of levee crown looking d/s.

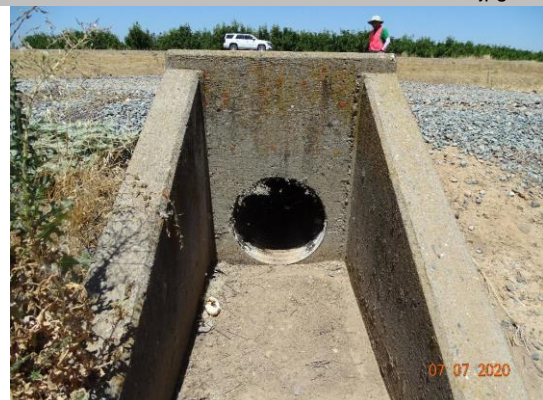
Photo 2 of 3 : UCIP_FA_2023_79100_87099.jpg

View of pipe inlet and headwall located at the LS levee toe.

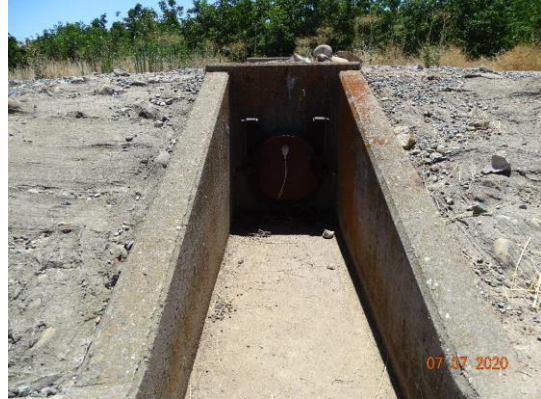
Photo 3 of 3 : UCIP_FA_2023_79100_87100.jpg

View of pipe outlet, flap gate, and headwall located on the WS berm.

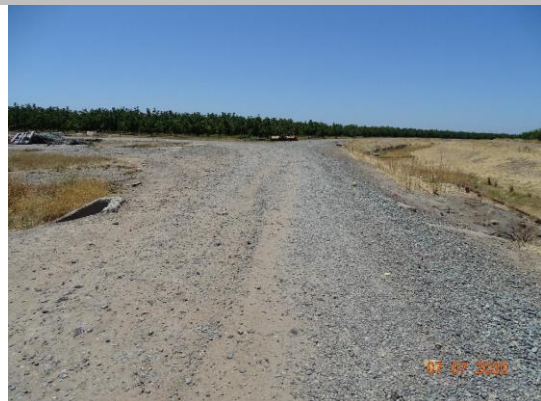
Photo 1 of 3 : UCIP_FA_2023_79101_87101.jpg

DS_ID:23905
 FS_ID:79101
 EP_NO: N/A
 Repair Type: Non-Urgent
 EVAL Issue:
 Crossing Status: Found
 UCIP Comments: 07/07/2020 Crossing evaluated as "Non-Urgent" because there was no permit found authorizing this pipe. Pipe inlet is clear of debris. (A. McDonald - DWR UCIP)
 06/12/2014 Pipe is covered with soil at inlet on LS. (DWR UCIP)
 FIELD_STRUCT_DESC: 24-inch corrugated metal drainage pipe through the levee, 3.5 feet below the crown. Concrete U-shaped headwalls on both ends. Flap gate on the waterside (WS) end. Cobble grouted outlet. Cobble grouted intake on the landside (LS). [Additional Reference(s): DWR Levee Log, 1978, (HLM 1.90). USACE San Joaquin O&M Manual 612.2, 1967, (HLM 1.90), 24-inch pipe listed].
 FS Date: 7/7/2020

Overview of levee crown looking d/s.

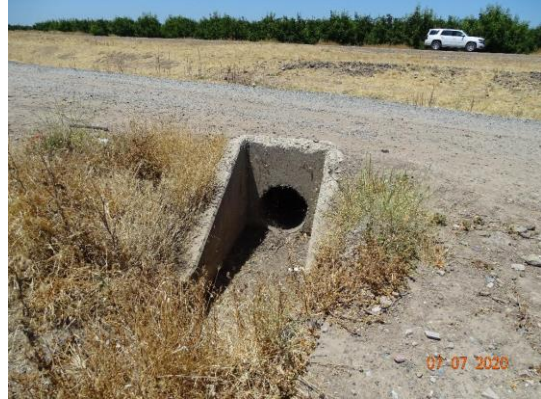
Photo 2 of 3 : UCIP_FA_2023_79101_87102.jpg

View of pipe inlet and headwall located at the LS levee toe.

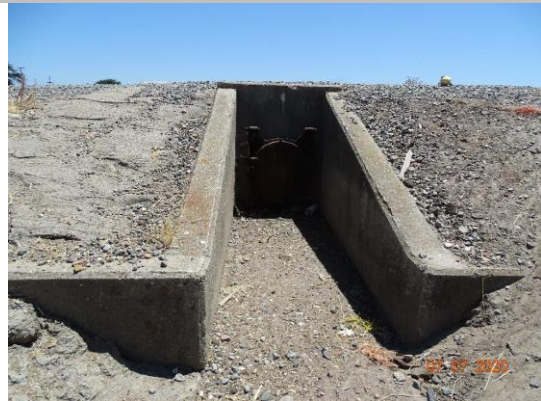
Photo 3 of 3 : UCIP_FA_2023_79101_87103.jpg

View of pipe outlet, flap gate, and headwall located at the WS levee toe.

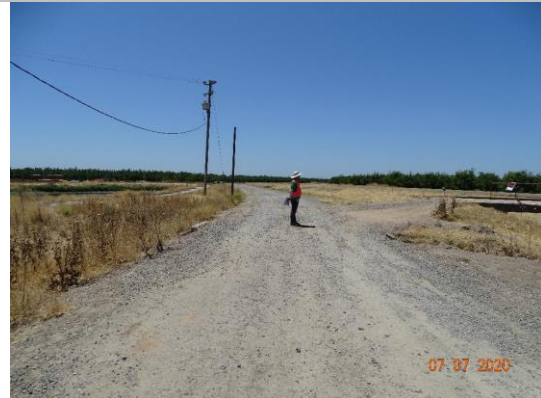
Photo 1 of 3 : UCIP_FA_2023_79102_87104.jpg

Comment Code						
Inspector Comment						
DS_ID:23906 FS_ID:79102 EP_NO: N/A Repair Type: Non-Urgent EVAL Issue: Crossing Status: Found UCIP Comments: 07/07/2020 Crossing evaluated as "Non-Urgent" because there was no permit found authorizing this pipe. Pipe no longer buried and not abandoned. Video inspection performed on 04-22-2020. (A. McDonald - DWR UCIP) 06/12/2014 Pipe buried on both ends and appears to be abandoned. IF so, it should be done so properly. (DWR UCIP) FIELD_STRUCT_DESC: 24-inch corrugated metal drainage pipe through the levee, 4 feet below the crown. Concrete U-shaped headwall on both ends. Flap gate on the waterside (WS) end. Cobble grouted outlet. Cobble grouted intake on the landside (LS). [Additional Reference(s): DWR Levee Log, 1978, (HLM 1.96). USACE San Joaquin O&M Manual 612.2, 1967, (HLM 1.96), 24-inch pipe listed]. FS Date: 7/7/2020

Overview of levee crown looking d/s.

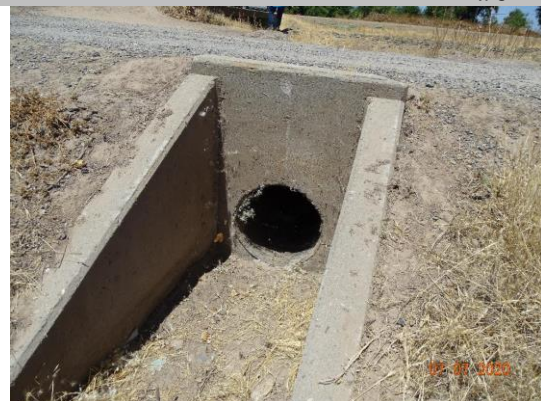
Photo 2 of 3 : UCIP_FA_2023_79102_87105.jpg

View of pipe inlet and headwall located at the LS levee toe.

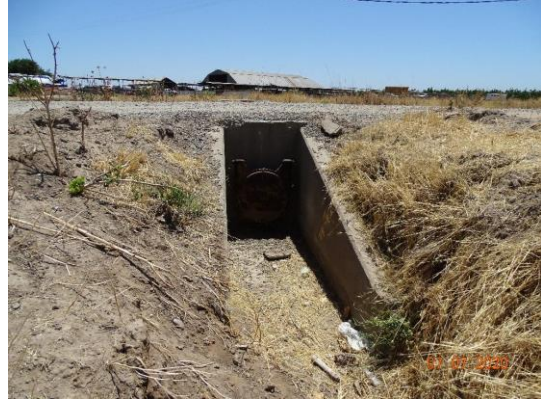
Photo 3 of 3 : UCIP_FA_2023_79102_87106.jpg

View of pipe outlet, flap gate, and headwall located at the WS levee toe.

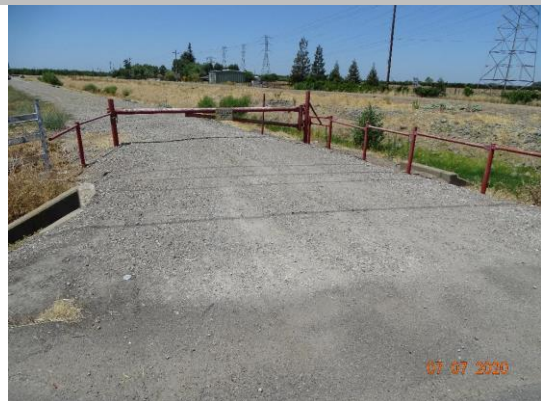
Photo 1 of 3 : UCIP_FA_2023_79103_87120.jpg

DS_ID:23908
 FS_ID:79103
 EP_NO: N/A
 Repair Type: Non-Urgent
 EVAL Issue:
 Crossing Status: Found
 UCIP Comments: 07/07/2020 Crossing evaluated as "Non-Urgent" because there was no permit found authorizing this pipe. Video inspection performed on 04-21-2020. (A. McDonald - DWR UCIP)
 FIELD_STRUCT_DESC: 24-inch corrugated metal drainage pipe through the levee, 4 feet below the crown. Concrete U-shaped headwalls on both ends. Flap gate on the waterside (WS) end. Cobble grouted outlet. Cobble grouted intake on the landside (LS). [Additional Reference(s): DWR Levee Log, 1978, (HLM 2.15). USACE San Joaquin O&M Manual 612.2, 1967, (HLM 2.15), 24-inch pipe listed].
 FS Date: 7/7/2020

Overview of levee crown looking d/s.

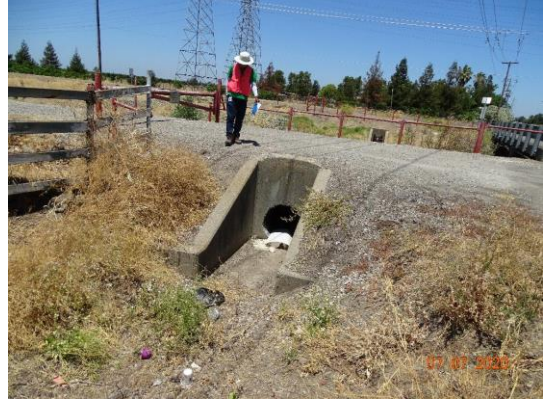
Photo 2 of 3 : UCIP_FA_2023_79103_87121.jpg

View of pipe inlet and headwall located at the LS levee toe.

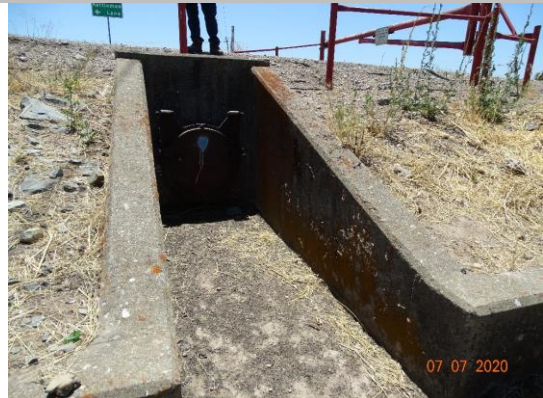
Photo 3 of 3 : UCIP_FA_2023_79103_87122.jpg

View of pipe outlet, flap gate, and headwall located at the WS levee toe.

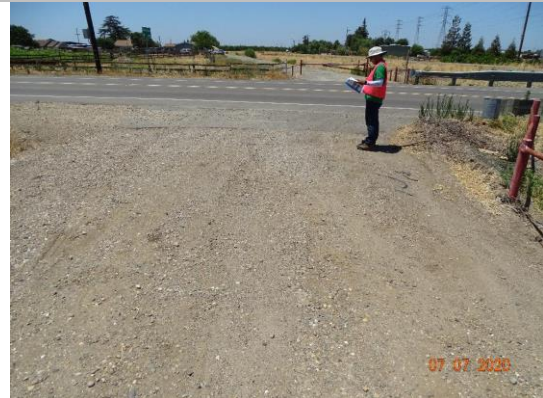
Photo 1 of 3 : UCIP_FA_2023_79104_87134.jpg

Comment Code					
Inspector Comment					
DS_ID:23909					
FS_ID:79104					
EP_NO: N/A					
Repair Type: Non-Urgent					
EVAL Issue:					
Crossing Status: Found					
UCIP Comments: 07/07/2020 Crossing evaluated as "Non-Urgent" because there was no permit found authorizing this pipe. (A. McDonald - DWR UCIP)					
FIELD_STRUCT_DESC: 24-inch corrugated metal drainage pipe through the levee, 5 feet below the crown. Concrete U-shaped headwalls on both ends. Flap gate on the waterside (WS) end. Cobble grouted outlet. Cobble grouted intake on the landside (LS). [Additional Reference(s): DWR Levee Log, 1978 (HLM 2.16). USACE San Joaquin O&M Manual 612.2, 1967, (HLM 2.16), 24-inch pipe listed].					
FS Date: 7/7/2020

Overview of levee crown looking d/s.

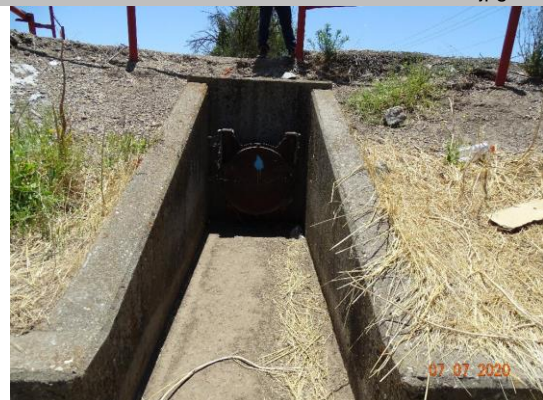
Photo 2 of 3 : UCIP_FA_2023_79104_87135.jpg

View of pipe outlet, flap gate, and headwall located at the WS levee toe.

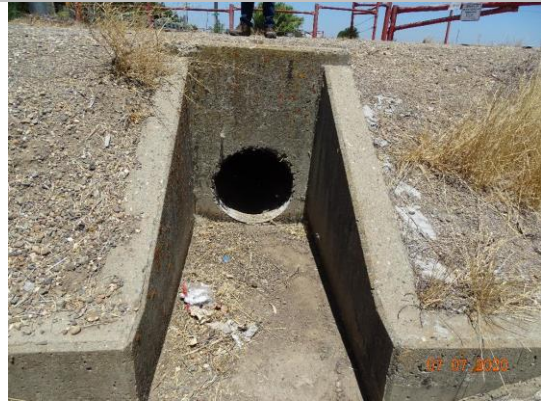
Photo 3 of 3 : UCIP_FA_2023_79104_87136.jpg

View of pipe inlet and headwall located at the LS levee toe.

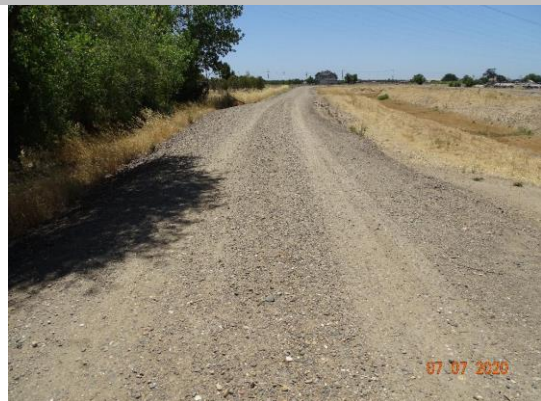
Photo 1 of 3 : UCIP_FA_2023_79105_87162.jpg

DS_ID:23911
 FS_ID:79105
 EP_NO: N/A
 Repair Type: Non-Urgent
 EVAL Issue:
 Crossing Status: Found
 UCIP Comments: 07/07/2020 Crossing evaluated as "Non-Urgent" because there was no permit found authorizing this pipe. (A. McDonald - DWR UCIP)
 FIELD_STRUCT_DESC: 24-inch corrugated metal drainage pipe through the levee, 6.0 feet below the crown. Concrete U-shaped headwalls on both ends. Flap gate on the waterside (WS) end. Cobble grouted outlet. Cobble grouted intake on the landside (LS). [Additional Reference(s): DWR Levee Log, 1978, (HLM 2.36). USACE San Joaquin O&M Manual 612.2, 1967, (HLM 2.36), 24-inch pipe listed].
 FS Date: 7/7/2020

Overview of levee crown looking d/s.

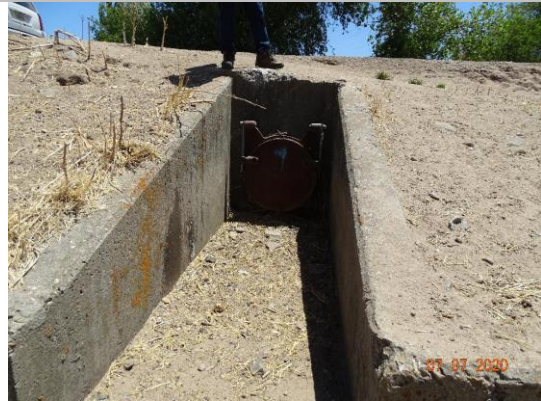
Photo 2 of 3 : UCIP_FA_2023_79105_87163.jpg

View of pipe outlet, flap gate, and headwall located at the WS levee toe.

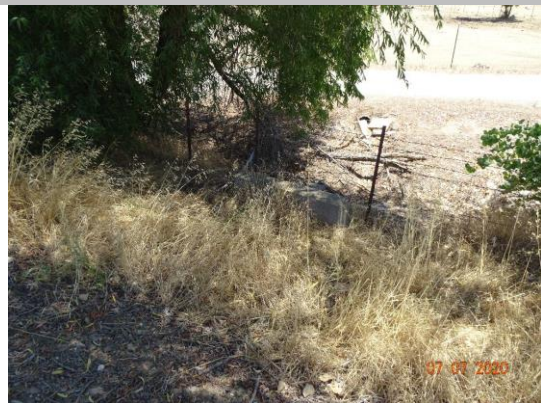
Photo 3 of 3 : UCIP_FA_2023_79105_87164.jpg

View of pipe inlet and headwall located at the LS levee toe.

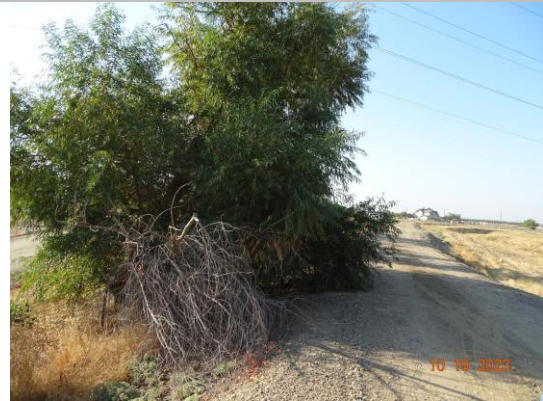
Photo 1 of 1 : FA_2023_NA0017_156_8_20231030_00071.jpg

LM Start	2.37	Rating **	M	Issue No.	8
LM End	2.40	Issue Type +	Ma	Location *	LS
Category	Earthen Levee			GPS Latitude/Longitude	
				Start	End
Item	Trim / Thin Trees			38.119141°	38.119473°
				-121.147713°	-121.147559°
DWR ID	DWR_NA0017_12_s_2012_8				
Comment Code					
T1 : Trim and thin trees to at least five feet above ground level to allow visibility of the ground and room to flood fight.					
Inspector Comment

View of untrimmed trees along the landside easement. Fall 2023

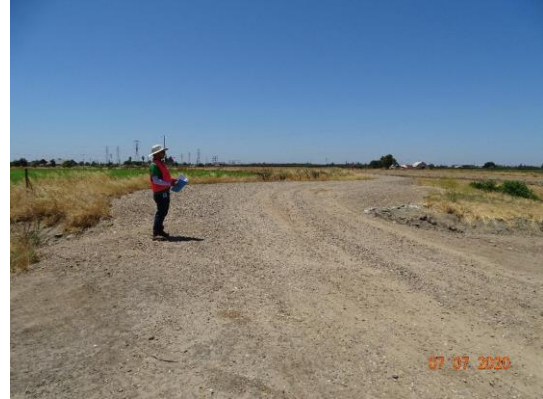
Photo 1 of 3 : UCIP_FA_2023_79114_87169.jpg

Comment Code						
Inspector Comment						
DS_ID:23913 FS_ID:79114 EP_NO: N/A Repair Type: Non-Urgent EVAL Issue: Crossing Status: Found UCIP Comments: 07/07/2020 Crossing evaluated as "Non-Urgent" because there was no permit found authorizing this pipe. (A. McDonald - DWR UCIP) 11/04/2016 Crossing has been downgraded from Urgent to Non-Urgent the silt buildup in front of the flap gate on the WS has been removed, however the sediment buildup inside the crossing still remains. Recommend clearing the sediment buildup inside the pipe and complete an internal integrity inspection to confirm crossing is in good condition. (O. Magana - DWR UCIP) 06/19/2014 Silt buildup on WS toe blocking flap gate operation. (W. Wylie - DWR UCIP) FIELD_STRUCT_DESC: 24-inch corrugated metal drainage pipe through the levee, 4 feet below the crown. Flap gate is located on the waterside (WS) end with a cobble grouted outlet. Cobble grouted intake on the landside (LS). [Additional Reference(s): DWR Levee Log, 1978, (HLM 2.61). USACE San Joaquin O&M Manual Unit 612.2, 1967, (HLM 2.61), 24-inch pipe listed]. FS Date: 7/7/2020

Overview of levee crown looking d/s.
